DRAFT ADA TRANSITION PLAN UPDATE
NEIGHBORHOOD AREA 1 NORTHWEST
SEPTEMBER 20, 2011

CITY OF CITRUS HEIGHTS

The Northwest Neighborhood Association

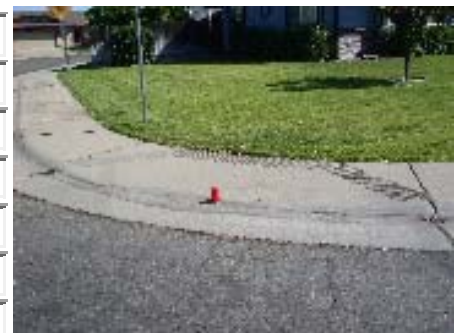
As Built Meas:	1	Quantity:	EACH
Description:	No truncated domes provided at curb ramp		
As Built Desc:	No detectable warnings at curb ramp		
Solution:	Provide compliant truncated domes		
Bar. Severity:	2 Recommended	Cost Estimate:	\$0.00
Implementation Priority:	4	Facility Function:	
Implementation Phase:		Implementation Date:	
Official Responsible:			
Notes:	Two - way intersection corners C,D

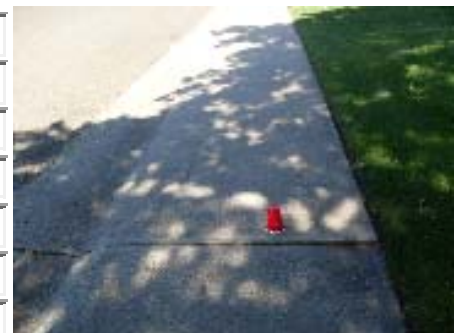
Field Date:	9/28/2010	Report Date:	9/28/2010	Barrier #:	16B
Location:	Irman Woods Cir - East				
X Coordinate:	-121.30865				
Y Coordinate:	38.72224				
Barrier Area:	Sidewalks				
Barrier Type:	Abrupt Change in Level - > 1/2"				
Code Ref:	CBC 1133B.7.1 and ADA/ABA 303.3				
As Built Meas:	4	Quantity:	LF		
Description:	Change in level greater than 1/2"				
As Built Desc:	1" lip in sidewalk surface				
Solution:	Grind or repair sidewalk to remove trip hazard				
Bar. Severity:	1 Necessary	Cost Estimate:	\$1,000.00	Status:	
Implementation Priority:	4	Facility Function:			
Implementation Phase:		Implementation Date:			
Official Responsible:

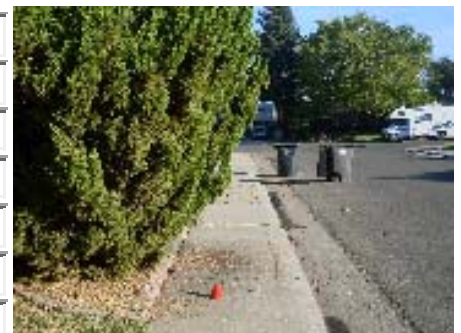
Barrier Type: Protruding Hazard

Code Ref: CBC 1133B.8.6.1 and ADA/ABA 307.2

As Built Desc: 24" protruding hazard at tree branches

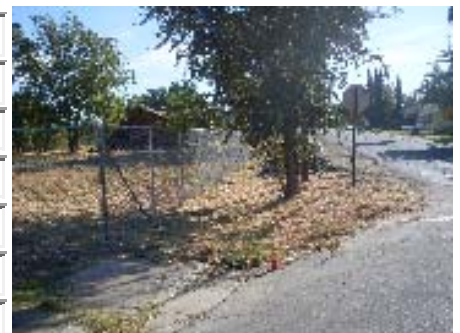
As Built Meas:	8	Quantity:	LF
Description:	No pedestrian route provided		
As Built Desc:	No sidewalk provided		
Solution:	Construct new firm and stable pedestrian route		
Bar. Severity:	1 Necessary	Cost Estimate:	\$800.00
Implementation Priority:	4	Facility Function:	
Implementation Phase:		Implementation Date:	
Official Responsible:			
Notes:

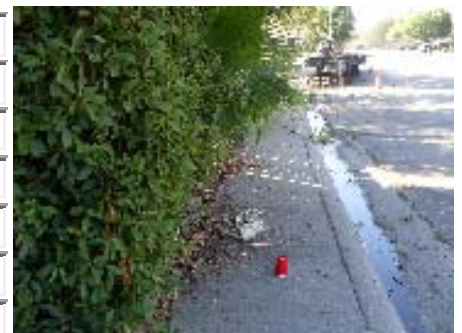
Barrier Type: Protruding Hazard

As Built Desc: 26" protruding hazard at tree branches

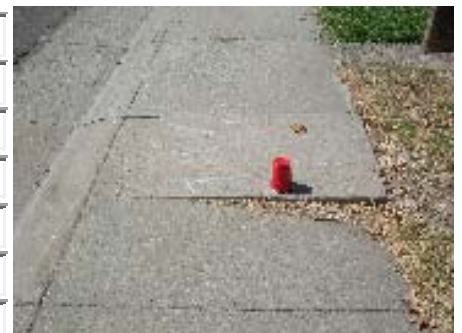
Field Date:	9/30/2010	Report Date:	9/30/2010	Barrier #:	122B
Location:	Canevalley Cir - North				
X Coordinate:	-121.30290				
Y Coordinate:	38.71874				
Barrier Area:	Sidewalks				
Barrier Type:	Abrupt Change in Level - > 1/2"				
Code Ref:	CBC 1133B.7.1 and ADA/ABA 303.3				
As Built Meas:	4	Quantity:	LF		
Description:	Change in level greater than 1/2"				
As Built Desc:	1" lip in sidewalk surface				
Solution:	Grind or repair to remove trip hazard				
Bar. Severity:	1 Necessary	Cost Estimate:	\$1,000.00	Status:	
Implementation Priority:	4	Facility Function:			
Implementation Phase:		Implementation Date:			
Official Responsible:

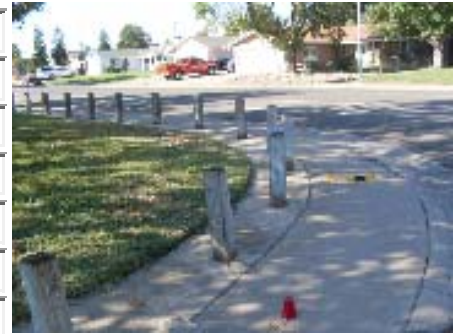
As Built Meas:	320	Quantity:	LF
Description:	Cross slope exceeds 2.0% (5.0% or more)		
As Built Desc:	6.4% cross slope		
Solution:	Demolish existing and construct new route		
Bar. Severity:	1 Necessary	Cost Estimate:	\$40,000.00
Implementation Priority:	2	Facility Function:	
Implementation Phase:		Implementation Date:	
Official Responsible:			
Notes:

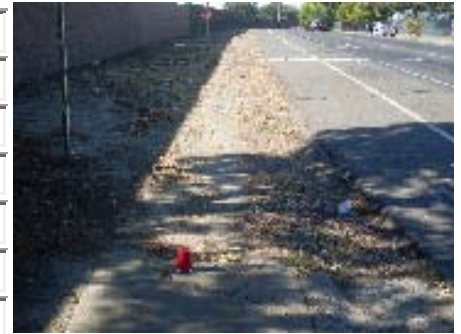
As Built Meas:	1	Quantity:	JOB
Description:	No barricade provided where sidewalk ends in hazardous location		
As Built Desc:	No barricade or other warning provided for the visually impaired at end of sidewalk		
Solution:	Provide barricade with cane detectable warning at end of sidewalk		
Bar. Severity:	1 Necessary	Cost Estimate:	\$1,350.00
Implementation Priority:	2	Facility Function:	
Implementation Phase:		Implementation Date:	
Official Responsible:			
Notes:

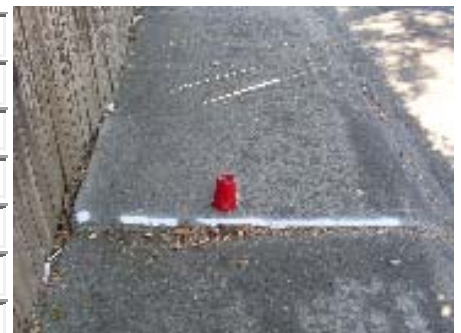
As Built Meas:	4	Quantity:	LF
Description:	Change in level greater than 1/2"		
As Built Desc:	1" lip in sidewalk surface		
Solution:	Grind or repair to remove trip hazard		
Bar. Severity:	1 Necessary	Cost Estimate:	\$1,000.00
Implementation Priority:	4	Facility Function:	
Implementation Phase:		Implementation Date:	
Official Responsible:			
Notes:

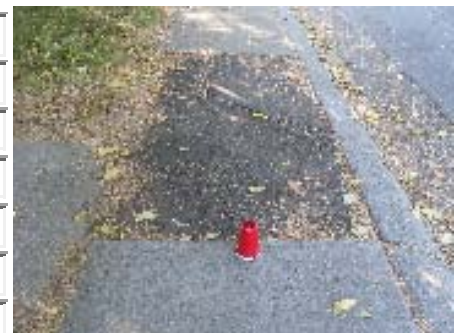
Barrier Type: Surface Condition - Damaged

Description: Surface is not firm and stable (cracked, broken or loose soil, etc.)

As Built Desc: Cracked concrete due to tree heaves

Solution: Repair surface to make firm and stable

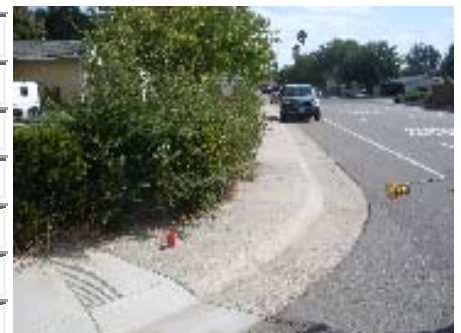
As Built Meas:	1	Quantity:	LF
Description:	Pedestrian route is not min. 48" wide (32" to 35")		
As Built Desc:	35" clear width due to foliage		
Solution:	Trim foliage to provide min. 48" clear width		
Bar. Severity:	2 Recommended	Cost Estimate:	\$125.00
Implementation Priority:	2	Facility Function:	
Implementation Phase:		Implementation Date:	
Official Responsible:			
Notes:

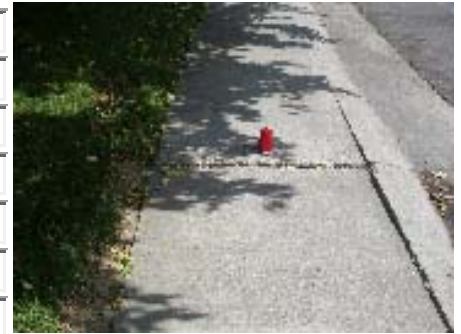
As Built Meas:	4	Quantity:	LF
Description:	Change in level greater than 1/2"		
As Built Desc:	1" lip in sidewalk surface		
Solution:	Grind or repair to remove trip hazard		
Bar. Severity:	1 Necessary	Cost Estimate:	\$1,000.00
Implementation Priority:	2	Facility Function:	
Implementation Phase:		Implementation Date:	
Official Responsible:			
Notes:

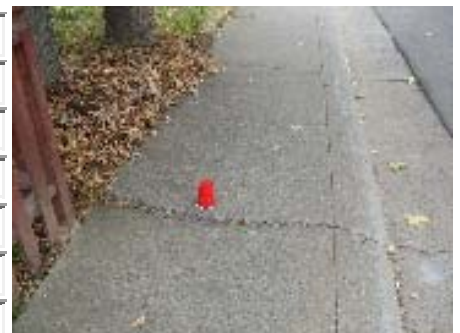
As Built Meas:	4	Quantity:	LF
Description:	Change in level greater than 1/2"		
As Built Desc:	1" lip in sidewalk surface		
Solution:	Grind or repair sidewalk to remove trip hazard		
Bar. Severity:	1 Necessary	Cost Estimate:	\$1,000.00
Implementation Priority:	4	Facility Function:	
Implementation Phase:		Implementation Date:	
Official Responsible:			
Notes:

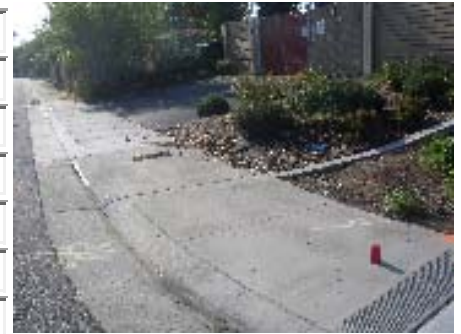
As Built Meas:	16	Quantity:	LF
Description:	Cross slope exceeds 2.0% (4.1% to 4.9%)		
As Built Desc:	4.4% cross slope		
Solution:	Demolish existing and construct new route		
Bar. Severity:	2 Recommended	Cost Estimate:	\$2,000.00
Implementation Priority:	2	Facility Function:	
Implementation Phase:		Implementation Date:	
Official Responsible:

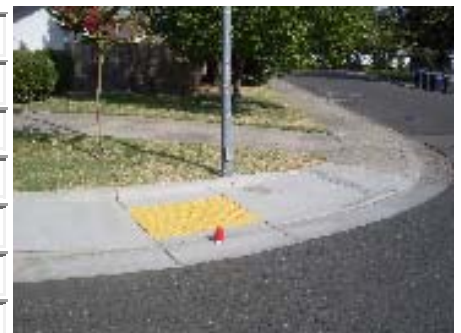
As Built Meas:	6	Quantity:	SF
Description:	Gutter slope exceeds 5.0%		
As Built Desc:	7.1% gutter slope		
Solution:	Demolish existing and construct new gutter		
Bar. Severity:	1 Necessary	Cost Estimate:	\$750.00
Implementation Priority:	3	Facility Function:	
Implementation Phase:		Implementation Date:	
Official Responsible:			
Notes:	Two - way intersection corners A,B. Corner B compliant

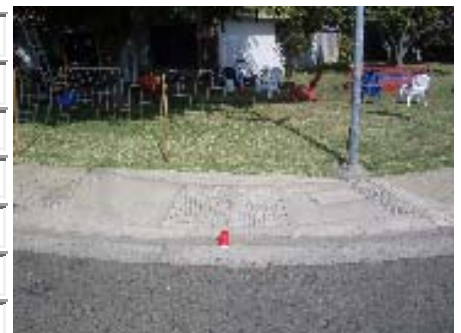
As Built Meas:	1	Quantity:	EACH
Description:	Curb ramp landing or pan not level(4.1% to 4.9%)		
As Built Desc:	4.1% landing slope		
Solution:	Demolish existing and construct new transition		
Bar. Severity:	2 Recommended	Cost Estimate:	\$0.00
Implementation Priority:	3	Facility Function:	
Implementation Phase:		Implementation Date:	
Official Responsible:			
Notes:	Four - way intersection corners A,B,C,D

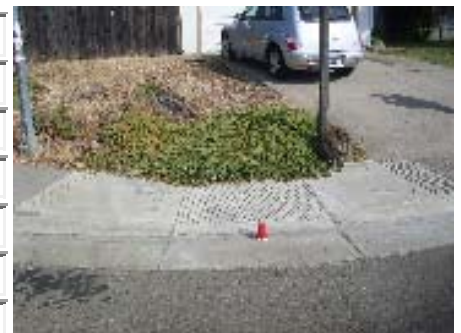
As Built Meas:	6	Quantity:	SF
Description:	Gutter slope exceeds 5.0% (5.9% - 6.5%)		
As Built Desc:	6.0% gutter slope		
Solution:	Demolish existing and construct new gutter		
Bar. Severity:	3 Hindrance	Cost Estimate:	\$0.00
Implementation Priority:	3	Facility Function:	
Implementation Phase:		Implementation Date:	
Official Responsible:			
Notes:	Four - way intersection corners A,B,C,D

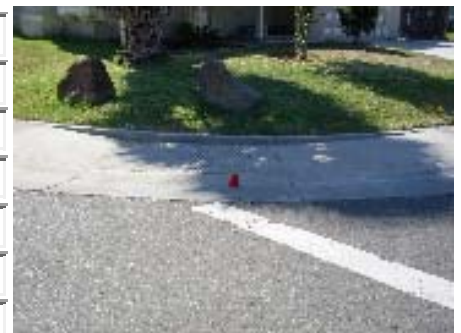
As Built Meas:	16	Quantity:	SF
Description:	Transition from gutter into roadway slope exceeds 5.0% (6.6% to 8.2%)		
As Built Desc:	7.4% transition into roadway at ramp landing		
Solution:	Demolish existing and construct new transition		
Bar. Severity:	2 Recommended	Cost Estimate:	\$0.00
Implementation Priority:	3	Facility Function:	
Implementation Phase:		Implementation Date:	
Official Responsible:			
Notes:	Four - way intersection corners A,B,C,D

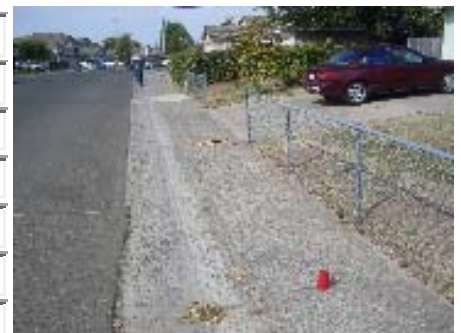
As Built Meas:	136	Quantity:	LF
Description:	Cross slope exceeds 2.0% (5.0% or more)		
As Built Desc:	5.4% cross slope		
Solution:	Demolish existing and construct new route		
Bar. Severity:	1 Necessary	Cost Estimate:	\$17,000.00
Implementation Priority:	3	Facility Function:	
Implementation Phase:		Implementation Date:	
Official Responsible:			
Notes:

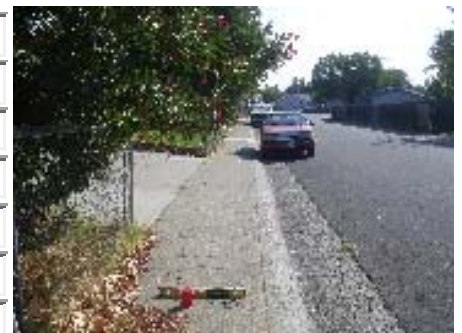
As Built Meas:	1	Quantity:	JOB
Description:	Protruding object in route of travel between 27" and 80" high		
As Built Desc:	60" protruding hazard at tree branches		
Solution:	Remove object or provide detectable warning		
Bar. Severity:	1 Necessary	Cost Estimate:	\$1,400.00
Implementation Priority:	4	Facility Function:	
Implementation Phase:		Implementation Date:	
Official Responsible:			
Notes:

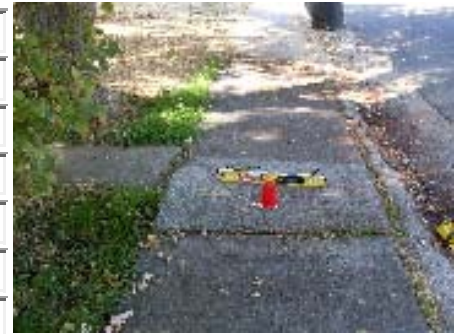
As Built Meas:	4	Quantity:	LF	
Description:	Change in level greater than 1/2"			
As Built Desc:	1/2" lip in sidewalk surface			
Solution:	Grind or repair sidewalk to remove trip hazard			
Bar. Severity:	1 Necessary	Cost Estimate:	\$1,000.00	Status:
Implementation Priority:	4	Facility Function:		
Implementation Phase:		Implementation Date:		
Official Responsible:				
Notes:

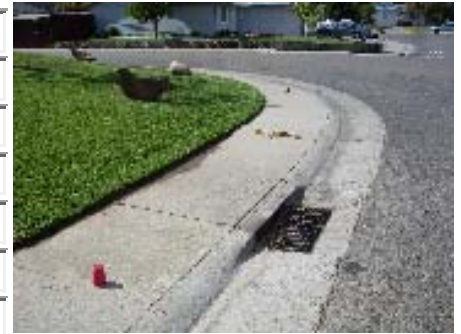
As Built Meas:	24	Quantity:	LF
Description:	Cross slope exceeds 2.0% (4.1% to 4.9%)		
As Built Desc:	4.1% cross slope		
Solution:	Demolish existing and construct new route		
Bar. Severity:	2 Recommended	Cost Estimate:	\$3,000.00
Implementation Priority:	4	Facility Function:	
Implementation Phase:		Implementation Date:	
Official Responsible:			
Notes:

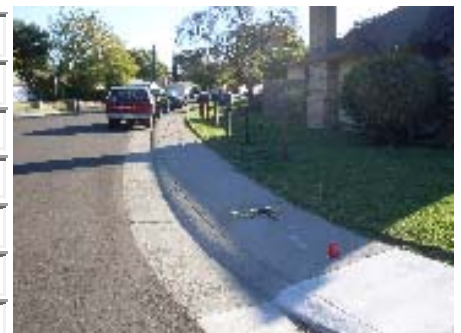
As Built Meas:	311	Quantity:	LF
Description:	Cross slope exceeds 2.0% (5.0% or more)		
As Built Desc:	5.5% cross slope		
Solution:	Demolish existing and construct new route		
Bar. Severity:	1 Necessary	Cost Estimate:	\$38,875.00
Implementation Priority:	4	Facility Function:	
Implementation Phase:		Implementation Date:	
Official Responsible:			
Notes:

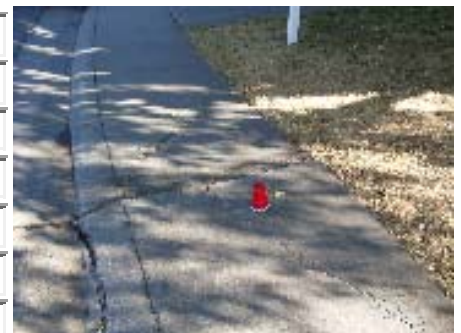
As Built Meas:	4	Quantity:	LF		
Description:	Change in level greater than 1/2"				
As Built Desc:	1" lip due to tree heaves				
Solution:	Grind or repair sidewalk to remove trip hazard				
Bar. Severity:	1 Necessary	Cost Estimate:	\$1,000.00	Status:	
Implementation Priority:	4	Facility Function:			
Implementation Phase:		Implementation Date:			
Official Responsible:					
Notes:

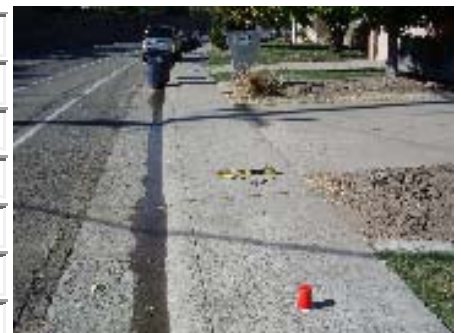
As Built Meas:	483	Quantity:	LF	
Description:	Cross slope exceeds 2.0% (4.1% to 4.9%)			
As Built Desc:	4.6% cross slope			
Solution:	Demolish existing and construct new route			
Bar. Severity:	2 Recommended	Cost Estimate:	\$60,375.00	Status:
Implementation Priority:	2	Facility Function:		
Implementation Phase:		Implementation Date:		
Official Responsible:				
Notes:

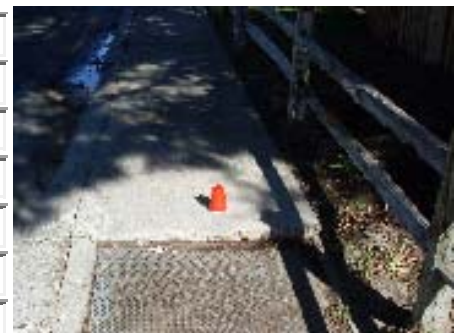
As Built Meas:	4	Quantity:	LF		
Description:	Change in level greater than 1/2"				
As Built Desc:	2" lip due to tree heaves				
Solution:	Grind or repair sidewalk to remove trip hazard				
Bar. Severity:	1 Necessary	Cost Estimate:	\$1,000.00	Status:	
Implementation Priority:	4	Facility Function:			
Implementation Phase:		Implementation Date:			
Official Responsible:					
Notes:

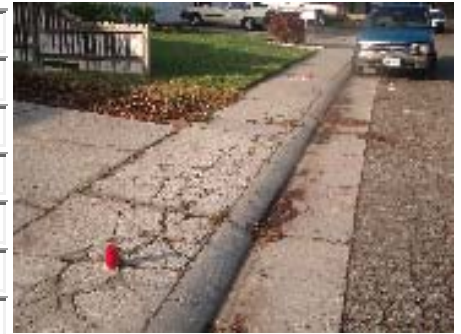
As Built Meas:	8	Quantity:	LF		
Description:	Surface is not firm and stable (cracked, broken or loose soil, etc.)				
As Built Desc:	Cracked concrete				
Solution:	Repair surface to make firm and stable				
Bar. Severity:	1 Necessary	Cost Estimate:	\$1,000.00	Status:	
Implementation Priority:	4	Facility Function:			
Implementation Phase:		Implementation Date:			
Official Responsible:					
Notes:

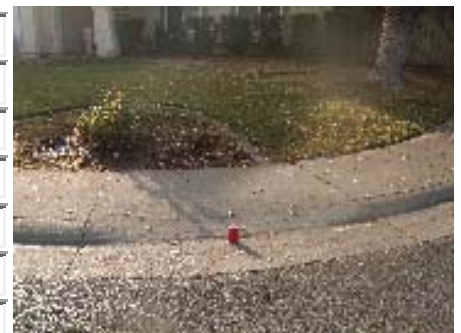
As Built Meas:	6	Quantity:	LF		
Description:	Cross slope at elbow exceeds 2.0% (5.0% or more)				
As Built Desc:	5.9% cross slope				
Solution:	Demolish existing and construct new sidewalk without curb ramp				
Bar. Severity:	1 Necessary	Cost Estimate:	\$750.00	Status:	
Implementation Priority:	4	Facility Function:			
Implementation Phase:		Implementation Date:			
Official Responsible:					
Notes:

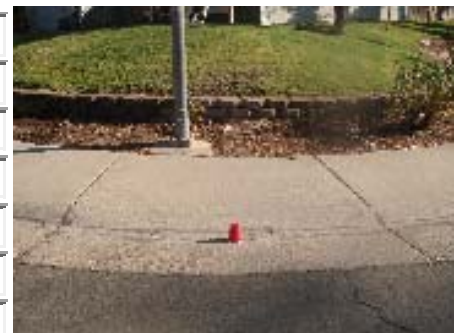
As Built Meas:	1	Quantity:	EACH
Description:	No compliant curb cut at corner (intersection)		
As Built Desc:	10.0% running slope at depressed area		
Solution:	Demolish existing and construct curb cut		
Bar. Severity:	1 Necessary	Cost Estimate:	\$2,500.00
Implementation Priority:	4	Facility Function:	
Implementation Phase:		Implementation Date:	
Official Responsible:			
Notes:	Two - way intersection corners B,C

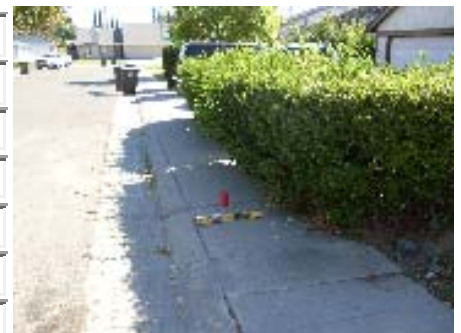
As Built Meas:	1	Quantity:	LF		
Description:	Pedestrian route is not min. 48" wide ($\leq 31"$ or less)				
As Built Desc:	24" clear width due to foliage				
Solution:	Trim foliage to provide min. 48" clear width				
Bar. Severity:	1 Necessary	Cost Estimate:	\$125.00	Status:	
Implementation Priority:	4	Facility Function:			
Implementation Phase:		Implementation Date:			
Official Responsible:					
Notes:

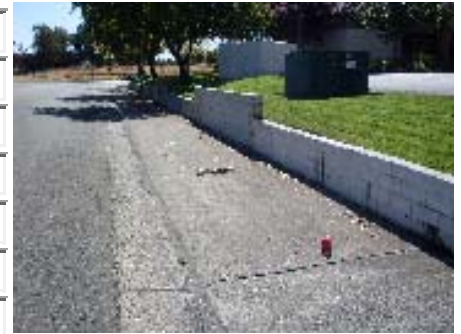
As Built Meas:	182	Quantity:	LF
Description:	Cross slope exceeds 2.0% (4.1% to 4.9%)		
As Built Desc:	4.2% cross slope		
Solution:	Demolish existing and construct new route		
Bar. Severity:	2 Recommended	Cost Estimate:	\$22,750.00
Implementation Priority:	4	Facility Function:	
Implementation Phase:		Implementation Date:	
Official Responsible:			
Notes:

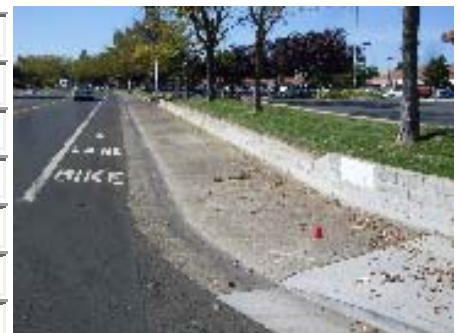
As Built Meas:	117	Quantity:	LF
Description:	Cross slope exceeds 2.0% (4.1% to 4.9%)		
As Built Desc:	4.6% cross slope		
Solution:	Demolish existing and construct new route		
Bar. Severity:	2 Recommended	Cost Estimate:	\$14,625.00
Implementation Priority:	2	Facility Function:	
Implementation Phase:		Implementation Date:	
Official Responsible:			
Notes:

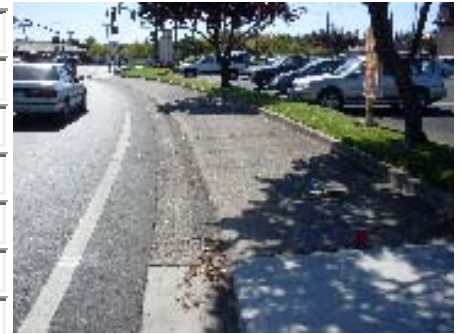
As Built Meas:	128	Quantity:	LF
Description:	Cross slope exceeds 2.0% (3.1% to 4.0%)		
As Built Desc:	3.9% cross slope		
Solution:	Demolish existing and construct new route		
Bar. Severity:	3 Hindrance	Cost Estimate:	\$16,000.00
Implementation Priority:	2	Facility Function:	
Implementation Phase:		Implementation Date:	
Official Responsible:			
Notes:

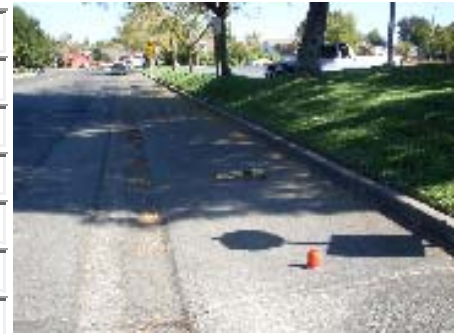
As Built Meas:	241	Quantity:	LF
Description:	Cross slope exceeds 2.0% (4.1% to 4.9%)		
As Built Desc:	4.5% cross slope		
Solution:	Demolish existing and construct new route		
Bar. Severity:	2 Recommended	Cost Estimate:	\$30,125.00
Implementation Priority:	3	Facility Function:	
Implementation Phase:		Implementation Date:	
Official Responsible:			
Notes:

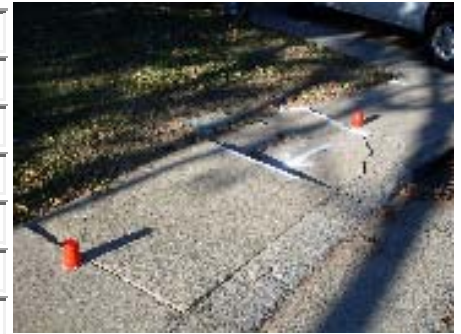
As Built Meas:	8	Quantity:	LF
Description:	Surface is not firm and stable (cracked, broken or loose soil, etc.)		
As Built Desc:	Cracked concrete		
Solution:	Repair surface to make firm and stable		
Bar. Severity:	1 Necessary	Cost Estimate:	\$1,000.00
Implementation Priority:	4	Facility Function:	
Implementation Phase:		Implementation Date:	
Official Responsible:			
Notes:

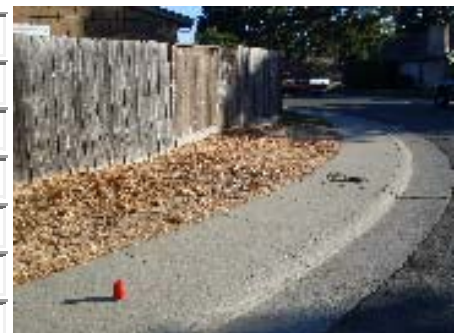
As Built Meas:	117	Quantity:	LF
Description:	Cross slope exceeds 2.0% (5.0% or more)		
As Built Desc:	5.2% cross slope		
Solution:	Demolish existing and construct new route		
Bar. Severity:	1 Necessary	Cost Estimate:	\$14,625.00
Implementation Priority:	4	Facility Function:	
Implementation Phase:		Implementation Date:	
Official Responsible:			
Notes:

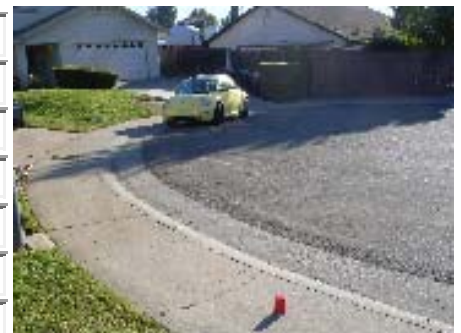
As Built Meas:	112	Quantity:	LF		
Description:	Cross slope exceeds 2.0% (4.1% to 4.9%)				
As Built Desc:	4.6% cross slope				
Solution:	Demolish existing and construct new route				
Bar. Severity:	2 Recommended	Cost Estimate:	\$14,000.00	Status:	
Implementation Priority:	4	Facility Function:			
Implementation Phase:		Implementation Date:			
Official Responsible:

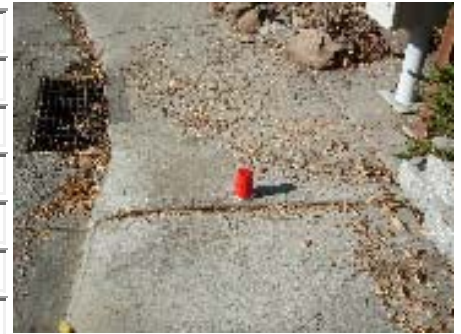
As Built Meas:	4	Quantity:	LF
Description:	Change in level greater than 1/2"		
As Built Desc:	1" lip in sidewalk surface		
Solution:	Grind or repair sidewalk to remove trip hazard		
Bar. Severity:	1 Necessary	Cost Estimate:	\$1,000.00
Implementation Priority:	4	Facility Function:	
Implementation Phase:		Implementation Date:	
Official Responsible:			
Notes:

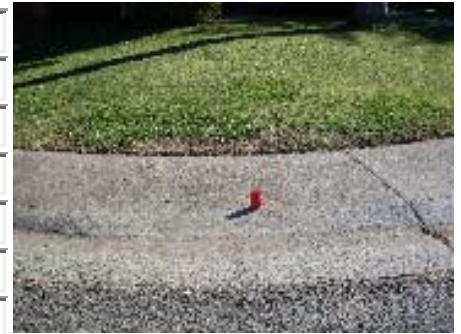
As Built Meas:	1	Quantity:	EACH
Description:	No compliant curb cut at corner (intersection)		
As Built Desc:	11.0% running slope at depressed area		
Solution:	Demolish existing and construct curb cut		
Bar. Severity:	1 Necessary	Cost Estimate:	\$2,500.00
Implementation Priority:	4	Facility Function:	
Implementation Phase:		Implementation Date:	
Official Responsible:			
Notes:	Two - way intersection corners B,C

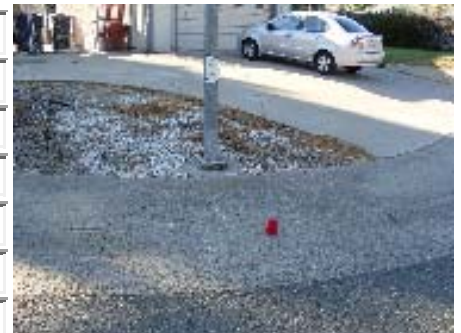
As Built Meas:	1	Quantity:	EACH
Description:	No compliant curb cut at corner (intersection)		
As Built Desc:	9.1% running slope at depressed curb		
Solution:	Demolish existing and construct curb cut		
Bar. Severity:	1 Necessary	Cost Estimate:	\$2,500.00
Implementation Priority:	4	Facility Function:	
Implementation Phase:		Implementation Date:	
Official Responsible:			
Notes:	Two - way intersection corners B,C

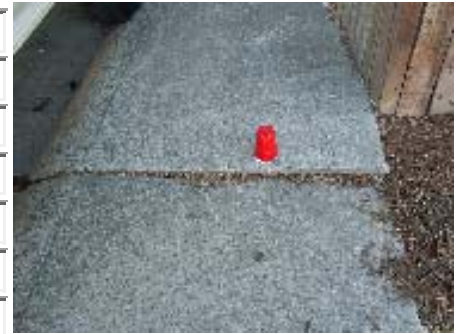
As Built Meas:	4	Quantity:	LF
Description:	Change in level greater than 1/2"		
As Built Desc:	1-1/2" lip due to tree heaves		
Solution:	Grind or repair sidewalk to remove trip hazard		
Bar. Severity:	1 Necessary	Cost Estimate:	\$1,000.00
Implementation Priority:	4	Facility Function:	
Implementation Phase:		Implementation Date:	
Official Responsible:			
Notes:

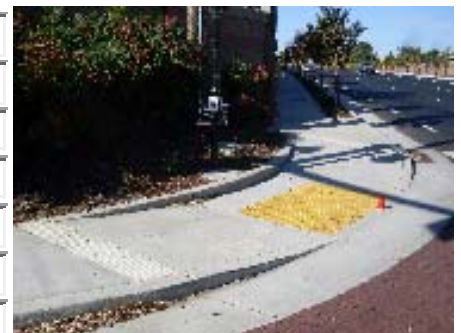
As Built Meas:	6	Quantity:	SF
Description:	Gutter slope exceeds 5.0% (6.6% to 8.2%)		
As Built Desc:	7.2% gutter slope		
Solution:	Demolish existing and construct new gutter		
Bar. Severity:	2 Recommended	Cost Estimate:	\$0.00
Implementation Priority:	1	Facility Function:	
Implementation Phase:		Implementation Date:	
Official Responsible:			
Notes:	Four - way intersection corners A,B,C,D. Corner C compliant, Signalized control compliant

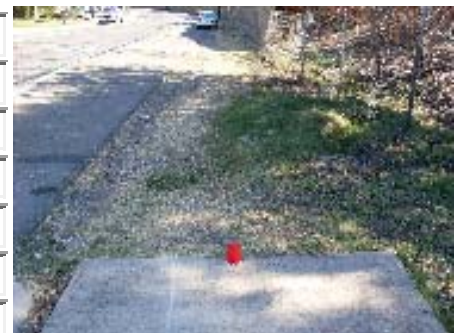
As Built Meas:	1	Quantity:	JOB
Description:	No barricade provided where sidewalk ends in hazardous location		
As Built Desc:	No barricade or other warning provided at end of sidewalk for the visually impaired		
Solution:	Provide barricade with cane detectable warning at end of sidewalk		
Bar. Severity:	1 Necessary	Cost Estimate:	\$1,350.00
Implementation Priority:	2	Facility Function:	
Implementation Phase:		Implementation Date:	
Official Responsible:			
Notes:

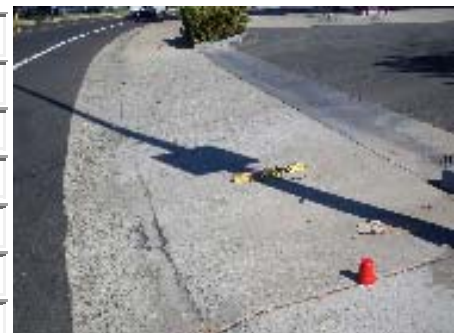
As Built Meas:	41	Quantity:	LF		
Description:	Driveway cross/running slope exceeds 2.0%				
As Built Desc:	6.6% cross slope, 8.6% running slope				
Solution:	Provide min. 48" wide level walkway through driveway				
Bar. Severity:	1 Necessary	Cost Estimate:	\$5,125.00	Status:	
Implementation Priority:	2	Facility Function:			
Implementation Phase:		Implementation Date:			
Official Responsible:					
Notes:

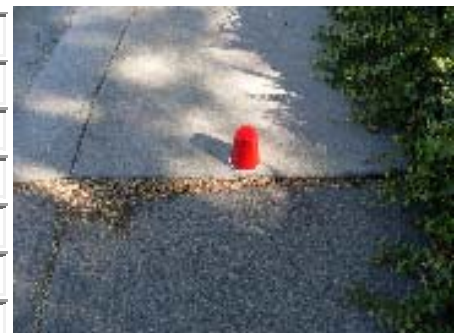
As Built Meas:	4	Quantity:	LF
Description:	Change in level greater than 1/2"		
As Built Desc:	1" lip in sidewalk surface		
Solution:	Grind or repair sidewalk to remove trip hazard		
Bar. Severity:	1 Necessary	Cost Estimate:	\$1,000.00
Implementation Priority:	4	Facility Function:	
Implementation Phase:		Implementation Date:	
Official Responsible:			
Notes:

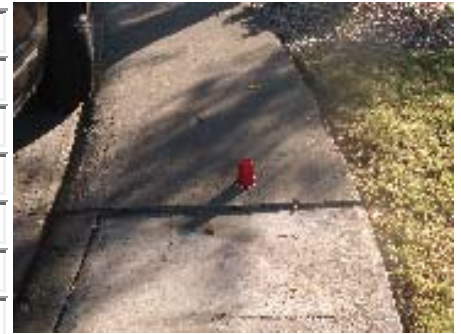
As Built Meas:	8	Quantity:	LF
Description:	Change in level greater than 1/2"		
As Built Desc:	1/2" lip in sidewalk surface		
Solution:	Grind or repair sidewalk to remove trip hazard		
Bar. Severity:	1 Necessary	Cost Estimate:	\$2,000.00
Implementation Priority:	4	Facility Function:	
Implementation Phase:		Implementation Date:	
Official Responsible:			
Notes:

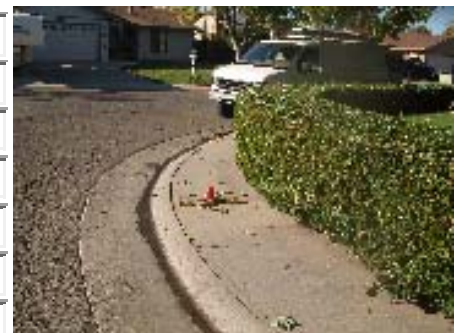
As Built Meas:	1	Quantity:	LF		
Description:	Pedestrian route is not min. 48" wide (32" to 35")				
As Built Desc:	35" clear width due to foliage				
Solution:	Trim foliage to provide min. 48" clear width				
Bar. Severity:	2 Recommended	Cost Estimate:	\$125.00	Status:	
Implementation Priority:	4	Facility Function:			
Implementation Phase:		Implementation Date:			
Official Responsible:					
Notes:

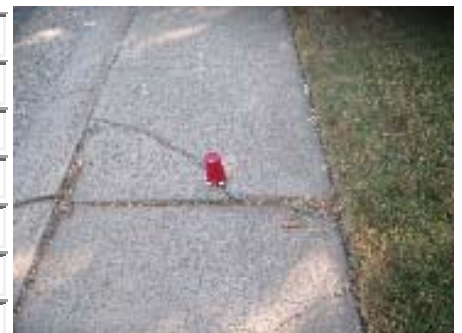
As Built Meas:	4	Quantity:	LF		
Description:	Change in level greater than 1/2"				
As Built Desc:	1/2" lip in sidewalk surface				
Solution:	Grind or repair sidewalk to remove trip hazard				
Bar. Severity:	1 Necessary	Cost Estimate:	\$1,000.00	Status:	
Implementation Priority:	4	Facility Function:			
Implementation Phase:		Implementation Date:			
Official Responsible:

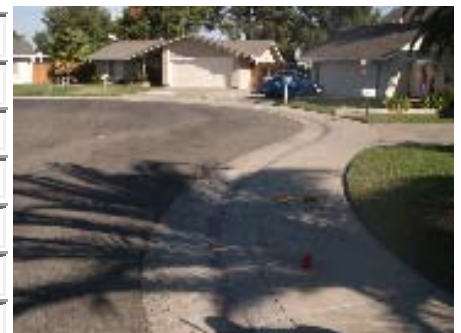
As Built Meas:	109	Quantity:	LF
Description:	Cross slope exceeds 2.0% (4.1% to 4.9%)		
As Built Desc:	4.6% cross slope		
Solution:	Demolish existing and construct new route		
Bar. Severity:	2 Recommended	Cost Estimate:	\$13,625.00
Implementation Priority:	4	Facility Function:	
Implementation Phase:		Implementation Date:	
Official Responsible:			
Notes:

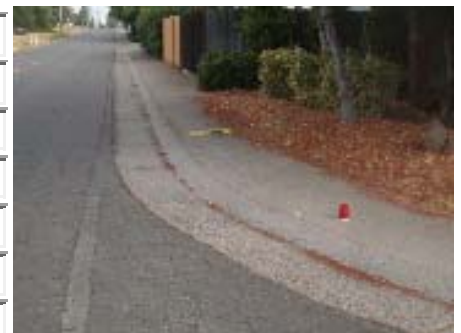
As Built Meas:	181	Quantity:	LF
Description:	Cross slope exceeds 2.0% (4.1% to 4.9%)		
As Built Desc:	4.6% cross slope		
Solution:	Demolish existing and construct new route		
Bar. Severity:	2 Recommended	Cost Estimate:	\$22,625.00
Implementation Priority:	4	Facility Function:	
Implementation Phase:		Implementation Date:	
Official Responsible:			
Notes:
