SZS CONSULTING GROUP

DRAFT ADA TRANSITION PLAN UPDATE
NEIGHBORHOOD AREA 3 CHANT
SEPTEMBER 20, 2011

CITY OF CITRUS HEIGHTS

Citrus Heights Area Three (CHANT)

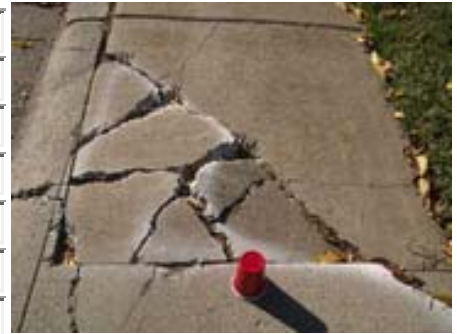
Barrier Type: Surface Condition - Damaged

Code Ref: CBC 1133B.7.1 and ADA/ABA 302.1

As Built Meas: 4 Quantity: LF

Description: Surface is not firm and stable (cracked, broken or loose soil, etc.)

As Built Desc: Cracked concrete

Solution: Repair surface to make firm and stable

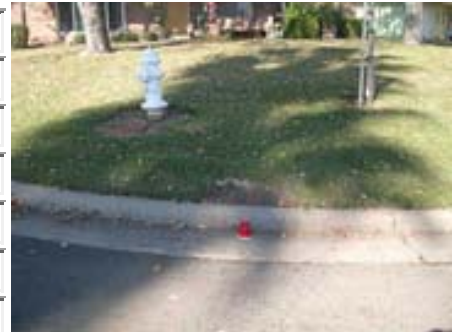
Field Date:	11/12/2010	Report Date:	11/12/2010	Barrier #:	2347
Location:	Skylane Dr and Van Maren Ln - Corner A				
X Coordinate:	-121.30878				
Y Coordinate:	38.70067				
Barrier Area:	Blended Transitions				
Barrier Type:	Detectable Warnings - Truncated Domes				
Code Ref:	CBC 1127B.5.3

As Built Meas:	1	Quantity:	EACH	
Description:	No truncated domes provided at transition into roadway			
As Built Desc:	No detectable warning provided			
Solution:	Provide compliant truncated domes			
Bar. Severity:	2 Recommended	Cost Estimate:	\$1,400.00	Status:
Implementation Priority:	4	Facility Function:		
Implementation Phase:		Implementation Date:		
Official Responsible:				
Notes:	Two - way intersection. Corners A,D

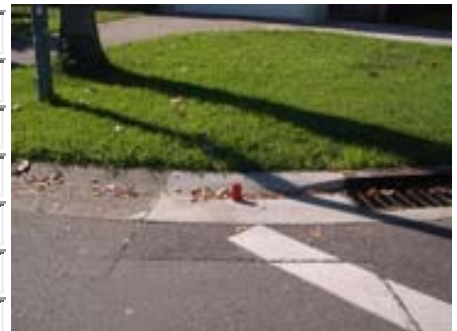
As Built Meas:	1	Quantity:	EACH	
Description:	No truncated domes provided at transition into roadway			
As Built Desc:	No detectable warning provided			
Solution:	Provide compliant truncated domes			
Bar. Severity:	2 Recommended	Cost Estimate:	\$1,400.00	Status:
Implementation Priority:	4	Facility Function:		
Implementation Phase:		Implementation Date:		
Official Responsible:				
Notes:	Two - way intersection. Corners A,D

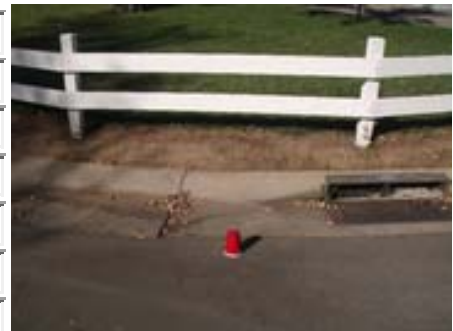
As Built Meas:	1	Quantity:	EACH	
Description:	No truncated domes provided at transition into roadway			
As Built Desc:	No detectable warning provided			
Solution:	Provide compliant truncated domes			
Bar. Severity:	2 Recommended	Cost Estimate:	\$1,400.00	Status:
Implementation Priority:	4	Facility Function:		
Implementation Phase:		Implementation Date:		
Official Responsible:

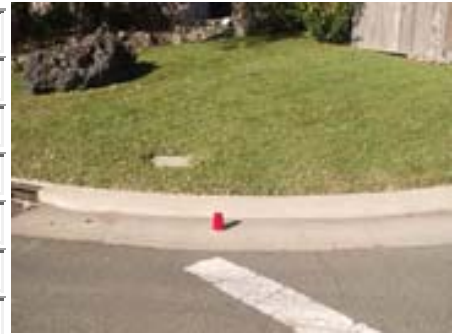
As Built Meas:	1	Quantity:	EACH	
Description:	No truncated domes provided at transition into roadway			
As Built Desc:	No detectable warning provided			
Solution:	Provide compliant truncated domes			
Bar. Severity:	2 Recommended	Cost Estimate:	\$1,400.00	Status:
Implementation Priority:	4	Facility Function:		
Implementation Phase:		Implementation Date:		
Official Responsible:				
Notes:	Two - way intersection. Corners A,B

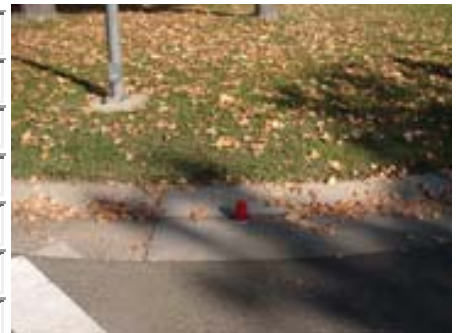
As Built Meas:	1	Quantity:	EACH	
Description:	No truncated domes provided at transition into roadway			
As Built Desc:	No detectable warning provided			
Solution:	Provide compliant truncated domes			
Bar. Severity:	2 Recommended	Cost Estimate:	\$1,400.00	Status:
Implementation Priority:	4	Facility Function:		
Implementation Phase:		Implementation Date:		
Official Responsible:				
Notes:	Two - way intersection. Corners A,B

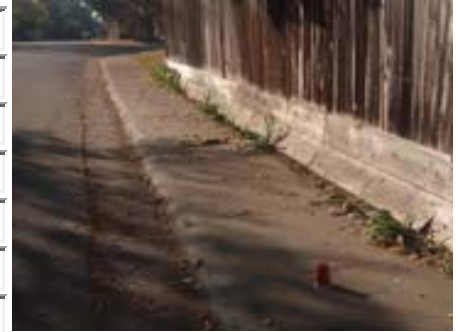
As Built Meas:	53	Quantity:	LF
Description:	Cross slope exceeds 2.0% (4.1% to 4.9%)		
As Built Desc:	4.3% cross slope		
Solution:	Demolish existing and construct new route		
Bar. Severity:	2 Recommended	Cost Estimate:	\$6,625.00
Implementation Priority:	4	Facility Function:	
Implementation Phase:		Implementation Date:	
Official Responsible:			
Notes:

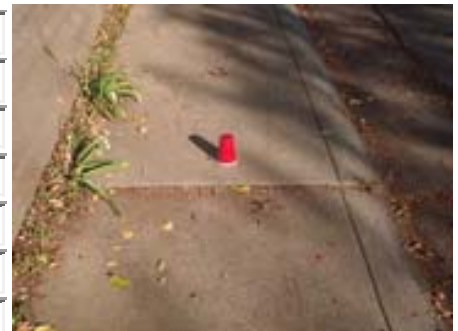
As Built Meas:	4	Quantity:	LF
Description:	Change in level greater than 1/2"		
As Built Desc:	1/2" lip in sidewalk surface		
Solution:	Grind or repair sidewalk to remove trip hazard		
Bar. Severity:	1 Necessary	Cost Estimate:	\$1,000.00
Implementation Priority:	4	Facility Function:	
Implementation Phase:		Implementation Date:	
Official Responsible:			
Notes:

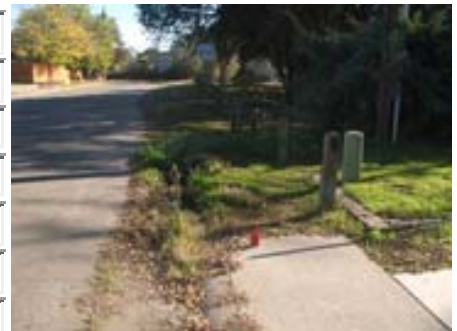
As Built Meas:	1	Quantity:	JOB
Description:	No barricade provided where sidewalk ends in hazardous location		
As Built Desc:	No barricade or other warning provided for the visually impaired at end of sidewalk		
Solution:	Provide barricade with cane detectable warning at end of sidewalk		
Bar. Severity:	1 Necessary	Cost Estimate:	\$1,350.00
Implementation Priority:	2	Facility Function:	
Implementation Phase:		Implementation Date:	
Official Responsible:			
Notes:

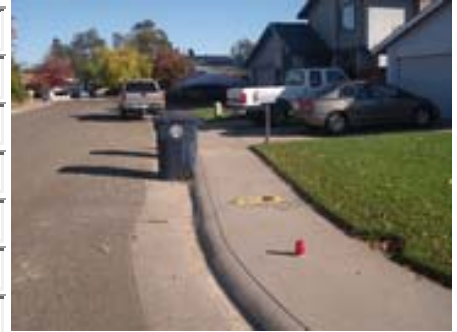
As Built Meas:	208	Quantity:	LF
Description:	Cross slope exceeds 2.0% (4.1% to 4.9%)		
As Built Desc:	4.4% cross slope		
Solution:	Demolish existing and construct new route		
Bar. Severity:	2 Recommended	Cost Estimate:	\$26,000.00
Implementation Priority:	4	Facility Function:	
Implementation Phase:		Implementation Date:	
Official Responsible:			
Notes:

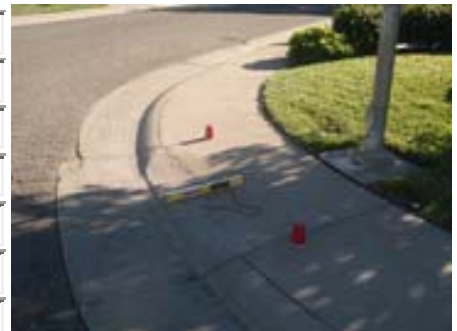
As Built Meas:	6	Quantity:	LF
Description:	Cross slope at elbow exceeds 2.0% (5.0% or more)		
As Built Desc:	12.2% cross slope		
Solution:	Demolish existing and construct new sidewalk without curb ramp		
Bar. Severity:	1 Necessary	Cost Estimate:	\$750.00
Implementation Priority:	4	Facility Function:	
Implementation Phase:		Implementation Date:	
Official Responsible:			
Notes:

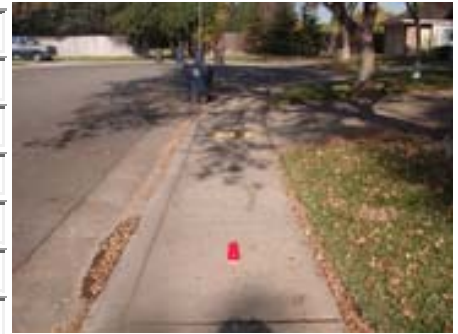
As Built Meas:	36	Quantity:	LF
Description:	Cross slope exceeds 2.0% (3.1% to 4.0%)		
As Built Desc:	3.1% cross slope		
Solution:	Demolish existing and construct new route		
Bar. Severity:	3 Hindrance	Cost Estimate:	\$4,500.00
Implementation Priority:	4	Facility Function:	
Implementation Phase:		Implementation Date:	
Official Responsible:			
Notes:

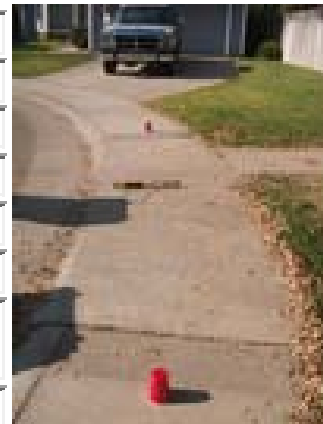
As Built Meas:	12	Quantity:	LF
Description:	Cross slope at elbow exceeds 2.0% (4.1% to 4.9%)		
As Built Desc:	4.5% cross slope		
Solution:	Demolish existing and construct new sidewalk without curb ramp		
Bar. Severity:	2 Recommended	Cost Estimate:	\$1,500.00
Implementation Priority:	4	Facility Function:	
Implementation Phase:		Implementation Date:	
Official Responsible:			
Notes:

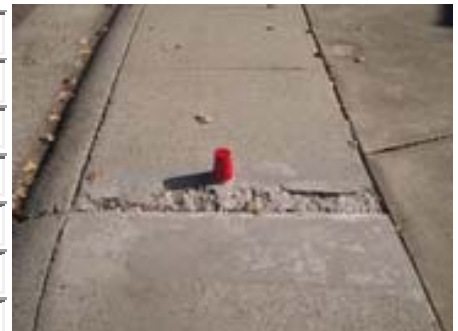
Barrier Type: Surface Condition - Damaged

Code Ref: CBC 1133B.7.1 and ADA/ABA 302.1

As Built Meas: 2 Quantity: LF

Description: Surface is not firm and stable (cracked, broken or loose soil, etc.)

As Built Desc: Broken concrete

Solution: Repair surface to make firm and stable

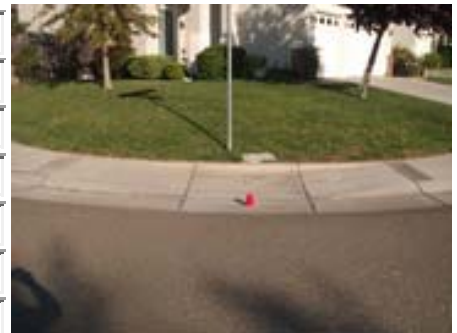
As Built Meas:	1	Quantity:	EACH	
Description:	No truncated domes provided at curb ramp			
As Built Desc:	No detectable warnings at curb ramp			
Solution:	Provide compliant truncated domes			
Bar. Severity:	2 Recommended	Cost Estimate:	\$0.00	Status:
Implementation Priority:	4	Facility Function:		
Implementation Phase:		Implementation Date:		
Official Responsible:				
Notes:	Three - way intersection. Corners B,C,D

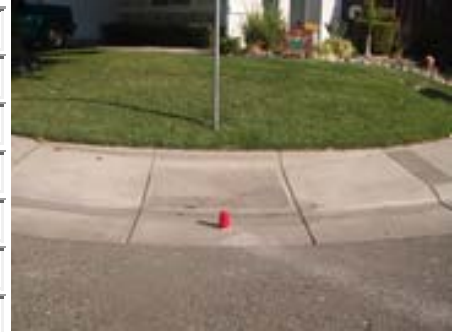
As Built Meas:	1	Quantity:	EACH
Description:	No truncated domes provided at curb ramp		
As Built Desc:	No detectable warnings at curb ramp		
Solution:	Provide compliant truncated domes		
Bar. Severity:	2 Recommended	Cost Estimate:	\$1,400.00
Implementation Priority:	4	Facility Function:	
Implementation Phase:		Implementation Date:	
Official Responsible:			
Notes:	Two - way intersection. Corners B,C

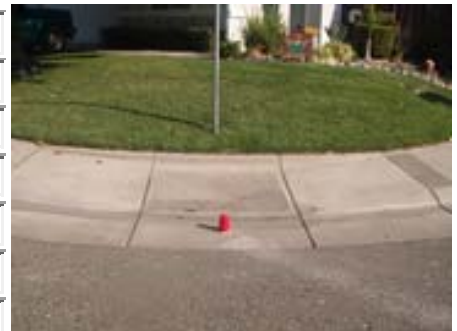
As Built Meas:	6	Quantity:	SF
Description:	Gutter slope exceeds 5.0% (5.9% - 6.5%)		
As Built Desc:	6.0% gutter slope		
Solution:	Demolish existing and construct new gutter		
Bar. Severity:	3 Hindrance	Cost Estimate:	\$750.00
Implementation Priority:	4	Facility Function:	
Implementation Phase:		Implementation Date:	
Official Responsible:			
Notes:	Two - way intersection. Corners B,C

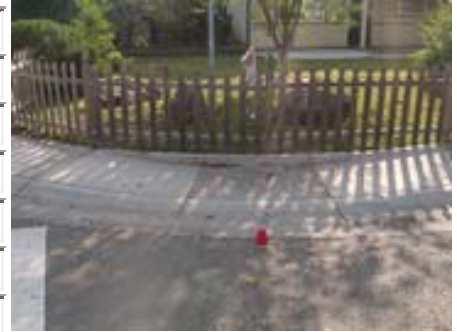
As Built Meas:	6	Quantity:	SF	
Description:	Gutter slope exceeds 5.0% (6.6% to 8.2%)			
As Built Desc:	8.0% gutter slope			
Solution:	Demolish existing and construct new gutter			
Bar. Severity:	2 Recommended	Cost Estimate:	\$750.00	Status:
Implementation Priority:	2	Facility Function:		
Implementation Phase:		Implementation Date:		
Official Responsible:				
Notes:	Two - way intersection. Corners C,D

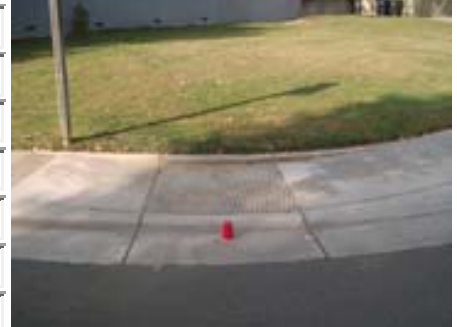
As Built Meas:	1	Quantity:	EACH	
Description:	No truncated domes provided at curb ramp			
As Built Desc:	No detectable warnings at curb ramp			
Solution:	Provide compliant truncated domes			
Bar. Severity:	2 Recommended	Cost Estimate:	\$1,400.00	Status:
Implementation Priority:	2	Facility Function:		
Implementation Phase:		Implementation Date:		
Official Responsible:				
Notes:	Two - way intersection. Corners C,D

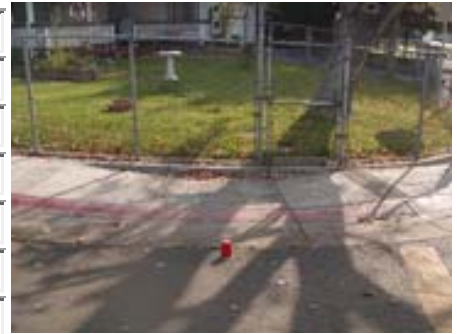
As Built Meas:	1	Quantity:	EACH
Description:	No truncated domes provided at curb ramp		
As Built Desc:	No detectable warnings at curb ramp		
Solution:	Provide compliant truncated domes		
Bar. Severity:	2 Recommended	Cost Estimate:	\$0.00
Implementation Priority:	4	Facility Function:	
Implementation Phase:		Implementation Date:	
Official Responsible:			
Notes:	Three - way intersection corners B,C,D

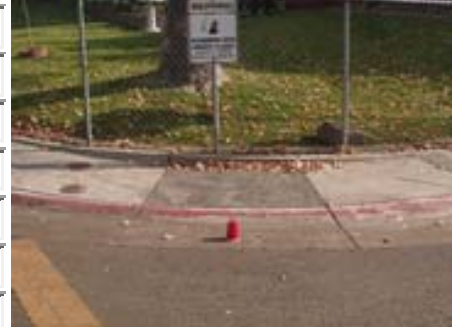
As Built Meas:	1	Quantity:	EACH
Description:	12" grooves at top of curb ramp are not level (2.1% to 3.0%)		
As Built Desc:	3.0% at 12" grooves		
Solution:	Demolish existing and construct new curb ramp		
Bar. Severity:	4 Low Severity	Cost Estimate:	\$2,500.00
Implementation Priority:	4	Facility Function:	
Implementation Phase:		Implementation Date:	
Official Responsible:			
Notes:	Three - way intersection. Corners B,C,D

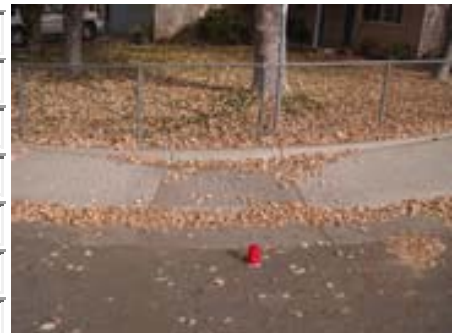
As Built Meas:	1	Quantity:	EACH
Description:	12" grooves at top of curb ramp are not level (4.1% to 4.9%)		
As Built Desc:	4.2% at 12" grooves		
Solution:	Demolish existing and construct new curb ramp		
Bar. Severity:	2 Recommended	Cost Estimate:	\$2,500.00
Implementation Priority:	2	Facility Function:	
Implementation Phase:		Implementation Date:	
Official Responsible:

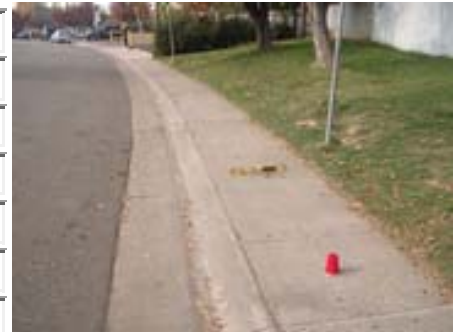
As Built Meas:	121	Quantity:	LF
Description:	Cross slope exceeds 2.0% (4.1% to 4.9%)		
As Built Desc:	4.7% cross slope		
Solution:	Demolish existing and construct new route		
Bar. Severity:	2 Recommended	Cost Estimate:	\$15,125.00
Implementation Priority:	4	Facility Function:	
Implementation Phase:		Implementation Date:	
Official Responsible:			
Notes:

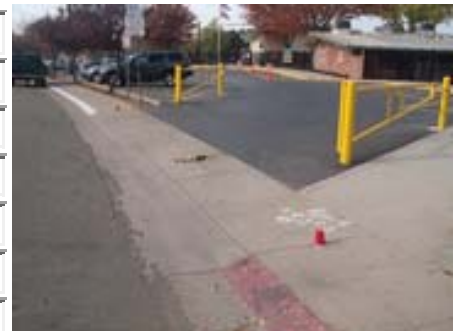
As Built Meas:	36	Quantity:	LF
Description:	Driveway cross slope exceeds 2.0% (5.0% or more)		
As Built Desc:	7.2% cross slope		
Solution:	Provide min. 48" wide level walkway through driveway		
Bar. Severity:	4 Low Severity	Cost Estimate:	\$4,500.00
Implementation Priority:	4	Facility Function:	
Implementation Phase:		Implementation Date:	
Official Responsible:			
Notes:

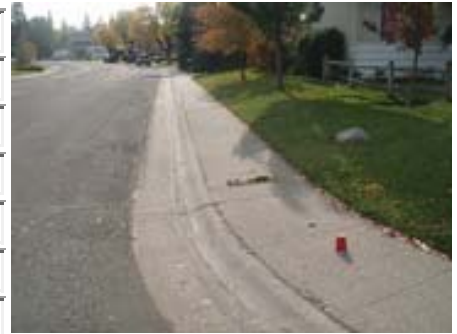
As Built Meas:	436	Quantity:	LF
Description:	Cross slope exceeds 2.0% (4.1% to 4.9%)		
As Built Desc:	4.7% cross slope		
Solution:	Demolish existing and construct new route		
Bar. Severity:	2 Recommended	Cost Estimate:	\$54,500.00
Implementation Priority:	4	Facility Function:	
Implementation Phase:		Implementation Date:	
Official Responsible:			
Notes:

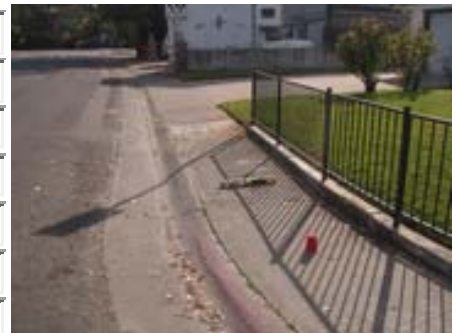
As Built Meas:	116	Quantity:	LF
Description:	Cross slope exceeds 2.0% (5.0% or more)		
As Built Desc:	7.0% cross slope		
Solution:	Demolish existing and construct new route		
Bar. Severity:	1 Necessary	Cost Estimate:	\$14,500.00
Implementation Priority:	4	Facility Function:	
Implementation Phase:		Implementation Date:	
Official Responsible:			
Notes:

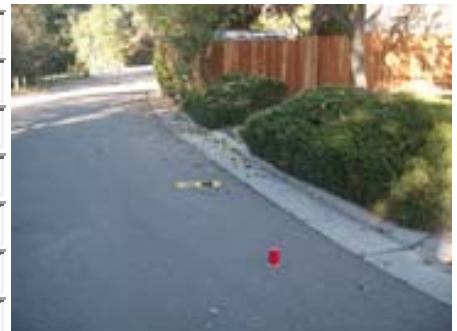
As Built Meas:	189	Quantity:	LF
Description:	Cross slope exceeds 2.0% (4.1% to 4.9%)		
As Built Desc:	4.4% cross slope		
Solution:	Demolish existing and construct new pedestrian route		
Bar. Severity:	2 Recommended	Cost Estimate:	\$23,625.00
Implementation Priority:	4	Facility Function:	
Implementation Phase:		Implementation Date:	
Official Responsible:			
Notes:

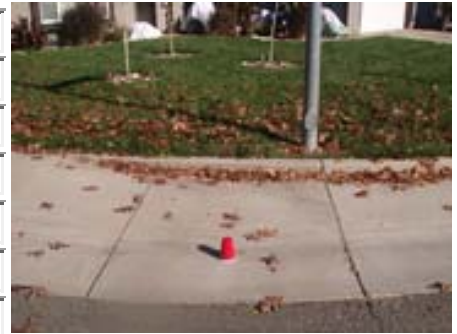
As Built Meas:	1	Quantity:	EACH	
Description:	No truncated domes provided at curb ramp			
As Built Desc:	No detectable warnings at curb ramp			
Solution:	Provide compliant truncated domes			
Bar. Severity:	2 Recommended	Cost Estimate:	\$1,400.00	Status:
Implementation Priority:	4	Facility Function:		
Implementation Phase:		Implementation Date:		
Official Responsible:				
Notes:	Two - way intersection. Corners B,C

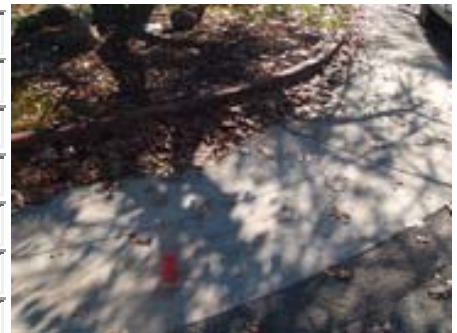
As Built Meas:	1	Quantity:	EACH	
Description:	No truncated domes provided at curb ramp			
As Built Desc:	No detectable warnings at curb ramp			
Solution:	Provide compliant truncated domes			
Bar. Severity:	2 Recommended	Cost Estimate:	\$1,400.00	Status:
Implementation Priority:	4	Facility Function:		
Implementation Phase:		Implementation Date:		
Official Responsible:				
Notes:	Two - way intersection. Corners B,C

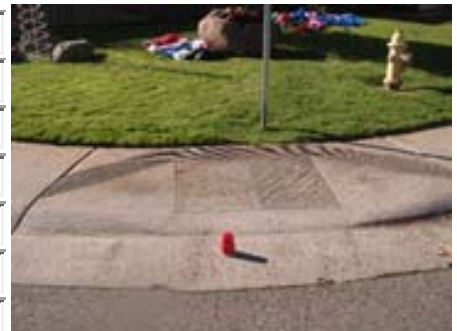
As Built Meas:	1	Quantity:	EACH
Description:	No truncated domes provided at curb ramp		
As Built Desc:	No detectable warnings at curb ramp		
Solution:	Provide compliant truncated domes		
Bar. Severity:	2 Recommended	Cost Estimate:	\$1,400.00
Implementation Priority:	4	Facility Function:	
Implementation Phase:		Implementation Date:	
Official Responsible:			
Notes:	Two - way intersection. Corners C,D

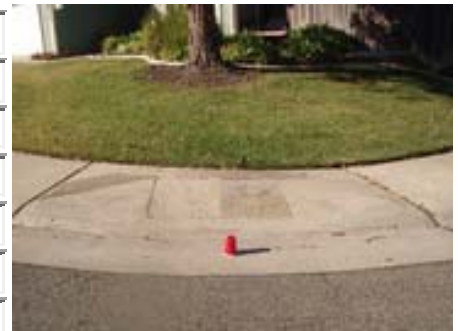
As Built Meas:	1	Quantity:	EACH	
Description:	No truncated domes provided at curb ramp			
As Built Desc:	No detectable warnings at curb ramp			
Solution:	Provide compliant truncated domes			
Bar. Severity:	2 Recommended	Cost Estimate:	\$0.00	Status:
Implementation Priority:	4	Facility Function:		
Implementation Phase:		Implementation Date:		
Official Responsible:				
Notes:	Two - way intersection. Corners A,B

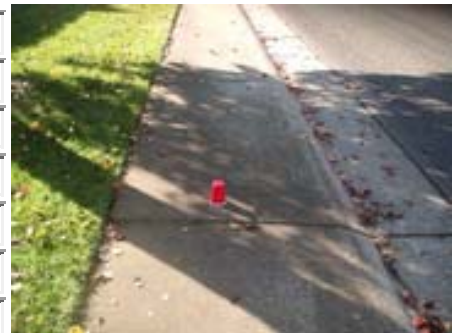
As Built Meas:	4	Quantity:	LF	
Description:	Change in level greater than $1/2"$			
As Built Desc:	$1/2"$ lip in sidewalk surface			
Solution:	Grind or repair sidewalk to remove trip hazard			
Bar. Severity:	1 Necessary	Cost Estimate:	\$1,000.00	Status:
Implementation Priority:	4	Facility Function:		
Implementation Phase:		Implementation Date:		
Official Responsible:				
Notes:

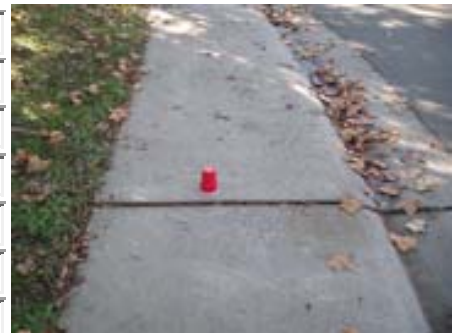
As Built Meas:	4	Quantity:	LF	
Description:	Change in level greater than 1/2"			
As Built Desc:	1/2" lip in sidewalk surface			
Solution:	Grind or repair sidewalk to remove trip hazard			
Bar. Severity:	1 Necessary	Cost Estimate:	\$1,000.00	Status:
Implementation Priority:	4	Facility Function:		
Implementation Phase:		Implementation Date:		
Official Responsible:				
Notes:

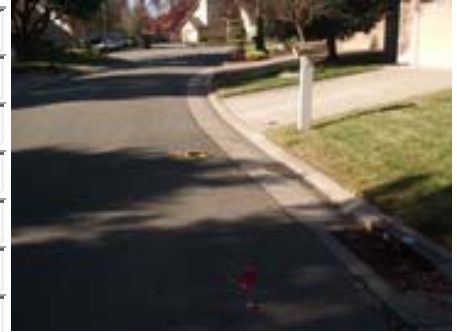
As Built Meas:	142	Quantity:	LF
Description:	Cross slope exceeds 2.0% (4.1% to 4.9%)		
As Built Desc:	4.5% cross slope		
Solution:	Demolish existing and construct new pedestrian route		
Bar. Severity:	2 Recommended	Cost Estimate:	\$17,750.00
Implementation Priority:	4	Facility Function:	
Implementation Phase:		Implementation Date:	
Official Responsible:			
Notes:

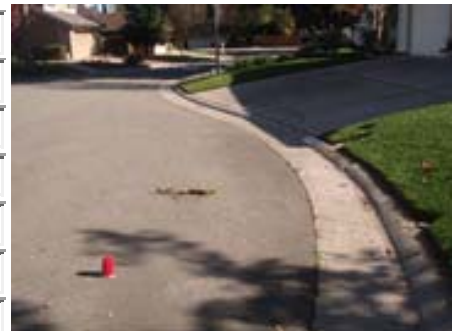
As Built Meas:	140	Quantity:	LF
Description:	Cross slope exceeds 2.0% (5.0% or more)		
As Built Desc:	7.1% cross slope		
Solution:	Demolish existing and construct new pedestrian route		
Bar. Severity:	1 Necessary	Cost Estimate:	\$17,500.00
Implementation Priority:	4	Facility Function:	
Implementation Phase:		Implementation Date:	
Official Responsible:			
Notes:

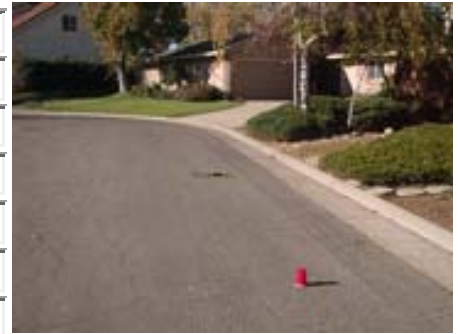
As Built Meas:	71	Quantity:	LF	
Description:	Cross slope exceeds 2.0% (3.1% to 4.0%)			
As Built Desc:	3.5% cross slope			
Solution:	Demolish existing and construct new pedestrian route			
Bar. Severity:	3 Hindrance	Cost Estimate:	\$8,875.00	Status:
Implementation Priority:	4	Facility Function:		
Implementation Phase:		Implementation Date:		
Official Responsible:				
Notes:

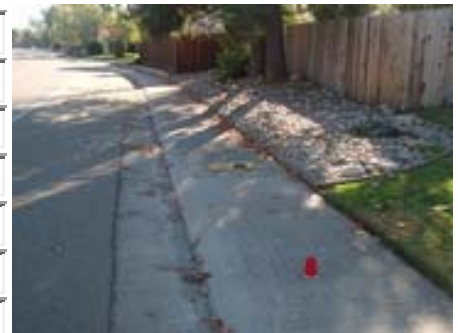
As Built Meas:	169	Quantity:	LF	
Description:	Cross slope exceeds 2.0% (4.1% to 4.9%)			
As Built Desc:	4.7% cross slope			
Solution:	Demolish existing and construct new route			
Bar. Severity:	2 Recommended	Cost Estimate:	\$21,125.00	Status:
Implementation Priority:	2	Facility Function:		
Implementation Phase:		Implementation Date:		
Official Responsible:				
Notes:

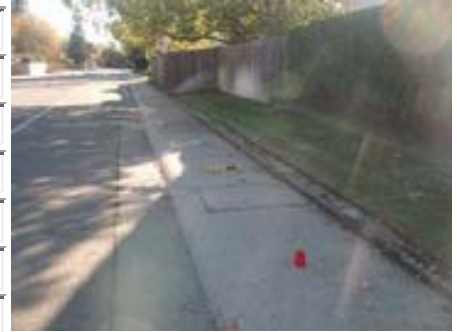
As Built Meas:	137	Quantity:	LF
Description:	Cross slope exceeds 2.0% (4.1% to 4.9%)		
As Built Desc:	4.5% cross slope		
Solution:	Demolish existing and construct new route		
Bar. Severity:	2 Recommended	Cost Estimate:	\$17,125.00
Implementation Priority:	2	Facility Function:	
Implementation Phase:		Implementation Date:	
Official Responsible:			
Notes:

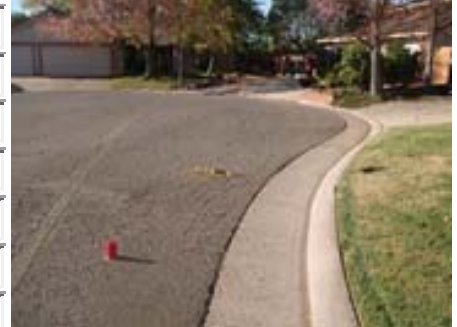
As Built Meas:	41	Quantity:	LF
Description:	Cross slope exceeds 2.0% (4.1% to 4.9%)		
As Built Desc:	4.7% cross slope		
Solution:	Demolish existing and construct new pedestrian route		
Bar. Severity:	2 Recommended	Cost Estimate:	\$5,125.00
Implementation Priority:	4	Facility Function:	
Implementation Phase:		Implementation Date:	
Official Responsible:			
Notes:

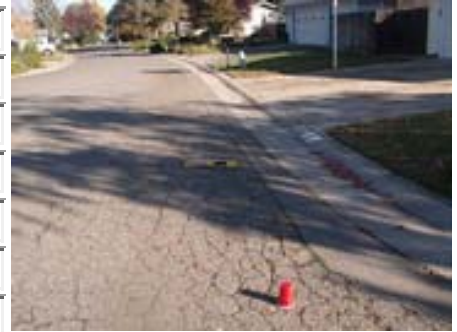
As Built Meas:	38	Quantity:	LF
Description:	Cross slope exceeds 2.0% (4.1% to 4.9%)		
As Built Desc:	4.6% cross slope		
Solution:	Demolish existing and construct new pedestrian route		
Bar. Severity:	2 Recommended	Cost Estimate:	\$4,750.00
Implementation Priority:	4	Facility Function:	
Implementation Phase:		Implementation Date:	
Official Responsible:			
Notes:

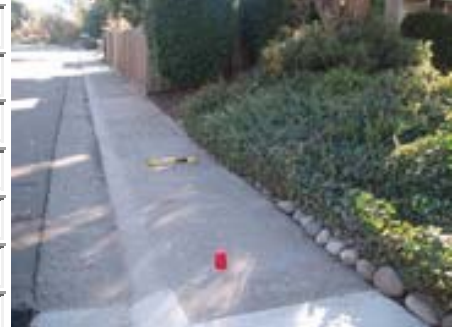
As Built Meas:	174	Quantity:	LF
Description:	Cross slope exceeds 2.0% (4.1% to 4.9%)		
As Built Desc:	4.2% cross slope		
Solution:	Demolish existing and construct new route		
Bar. Severity:	2 Recommended	Cost Estimate:	\$21,750.00
Implementation Priority:	2	Facility Function:	
Implementation Phase:		Implementation Date:	
Official Responsible:			
Notes:

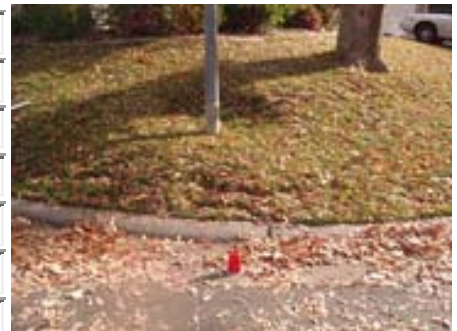
As Built Meas:	1	Quantity:	EACH	
Description:	No truncated domes provided at transition into roadway			
As Built Desc:	No detectable warning provided			
Solution:	Provide compliant truncated domes			
Bar. Severity:	2 Recommended	Cost Estimate:	\$1,400.00	Status:
Implementation Priority:	4	Facility Function:		
Implementation Phase:		Implementation Date:		
Official Responsible:
