**DRAFT ADA TRANSITION PLAN UPDATE  
NEIGHBORHOOD AREA 4 ARCADE CREEK  
SEPTEMBER 20, 2011**

CITY OF CITRUS HEIGHTS

## Arcade Creek Neighborhood Area

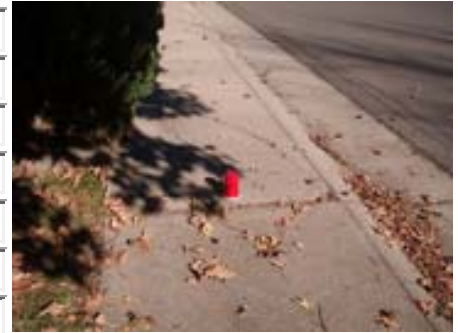
As Built Meas:	4	Quantity:	LF		
Description:	Change in level greater than 1/2"				
As Built Desc:	1/2" lip in sidewalk surface				
Solution:	Grind or repair sidewalk to remove trip hazard				
Bar. Severity:	1 Necessary	Cost Estimate:	\$1,000.00	Status:	
Implementation Priority:	4	Facility Function:			
Implementation Phase:		Implementation Date:			
Official Responsible:

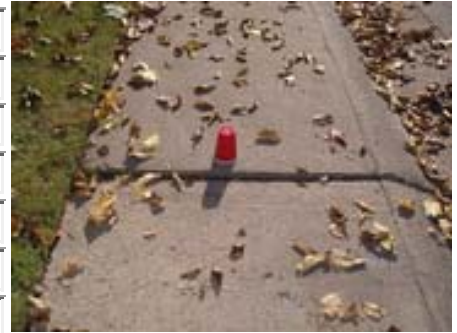
As Built Meas:	4	Quantity:	LF
Description:	Change in level greater than 1/2"		
As Built Desc:	1/2" lip in sidewalk surface		
Solution:	Grind or repair sidewalk to remove trip hazard		
Bar. Severity:	1 Necessary	Cost Estimate:	\$1,000.00
Implementation Priority:	4	Facility Function:	
Implementation Phase:		Implementation Date:	
Official Responsible:

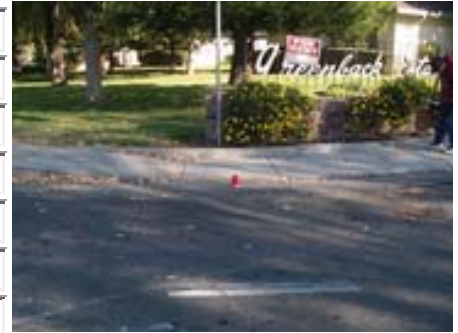
As Built Meas:	1	Quantity:	EACH	
Description:	No truncated domes provided at curb ramp			
As Built Desc:	No detectable warnings at curb ramp			
Solution:	Provide compliant truncated domes			
Bar. Severity:	2 Recommended	Cost Estimate:	\$1,400.00	Status:
Implementation Priority:	3	Facility Function:		
Implementation Phase:		Implementation Date:		
Official Responsible:

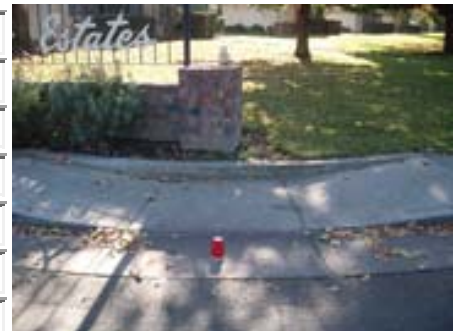
As Built Meas:	1	Quantity:	EACH	
Description:	No truncated domes provided at curb ramp			
As Built Desc:	No detectable warnings at curb ramp			
Solution:	Provide compliant truncated domes			
Bar. Severity:	2 Recommended	Cost Estimate:	\$1,400.00	Status:
Implementation Priority:	3	Facility Function:		
Implementation Phase:		Implementation Date:		
Official Responsible:

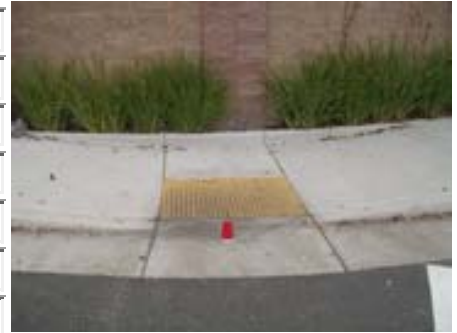
As Built Meas:	1	Quantity:	EACH		
Description:	12" grooves at top of curb ramp are not level (4.1% to 4.9%)				
As Built Desc:	4.6% at 12" grooves				
Solution:	Demolish existing and construct new curb ramp				
Bar. Severity:	2 Recommended	Cost Estimate:	\$2,500.00	Status:	
Implementation Priority:	1	Facility Function:			
Implementation Phase:		Implementation Date:			
Official Responsible:

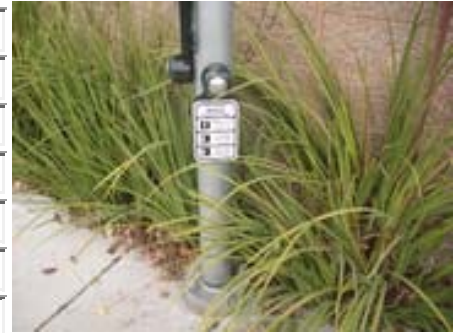
As Built Meas:	1	Quantity:	JOB		
Description:	No vibrotactile pedestrian buttons provided				
As Built Desc:	No vibrotactile buttons provided				
Solution:	Recommended: Provide vibrotactile ped buttons				
Bar. Severity:	1 Necessary	Cost Estimate:	\$4,700.00	Status:	
Implementation Priority:	1	Facility Function:			
Implementation Phase:		Implementation Date:			
Official Responsible:

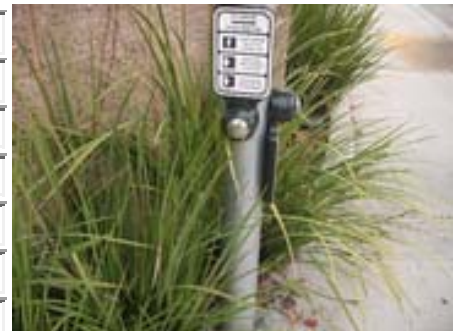
As Built Meas:	1	Quantity:	JOB		
Description:	No vibrotactile pedestrian buttons provided				
As Built Desc:	No vibrotactile buttons provided				
Solution:	Recommended: Provide vibrotactile ped buttons				
Bar. Severity:	1 Necessary	Cost Estimate:	\$4,700.00	Status:	
Implementation Priority:	1	Facility Function:			
Implementation Phase:		Implementation Date:			
Official Responsible:

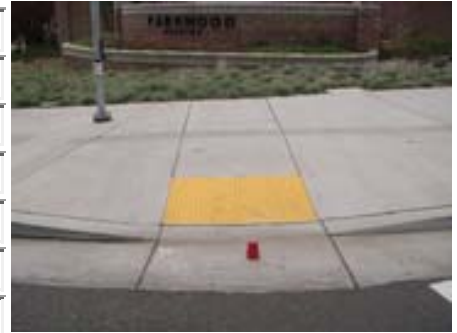
As Built Meas:	1	Quantity:	EACH
Description:	12" grooves at top of curb ramp are not level (4.1% to 4.9%)		
As Built Desc:	4.2% at 12" grooves		
Solution:	Demolish existing and construct new curb ramp		
Bar. Severity:	2 Recommended	Cost Estimate:	\$2,500.00
Implementation Priority:	1	Facility Function:	
Implementation Phase:		Implementation Date:	
Official Responsible:

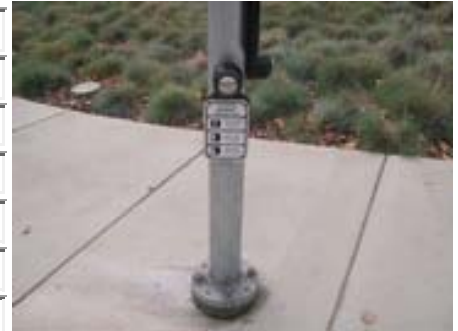
As Built Meas:	1	Quantity:	JOB		
Description:	No vibrotactile pedestrian buttons provided				
As Built Desc:	No vibrotactile buttons provided				
Solution:	Recommended: Provide vibrotactile ped buttons				
Bar. Severity:	1 Necessary	Cost Estimate:	\$4,700.00	Status:	
Implementation Priority:	1	Facility Function:			
Implementation Phase:		Implementation Date:			
Official Responsible:

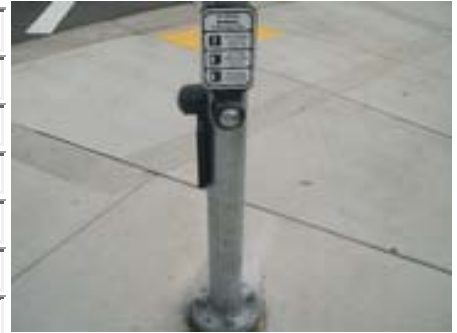
As Built Meas:	1	Quantity:	JOB		
Description:	No vibrotactile pedestrian buttons provided				
As Built Desc:	No vibrotactile buttons provided				
Solution:	Recommended: Provide vibrotactile ped buttons				
Bar. Severity:	1 Necessary	Cost Estimate:	\$4,700.00	Status:	
Implementation Priority:	1	Facility Function:			
Implementation Phase:		Implementation Date:			
Official Responsible:

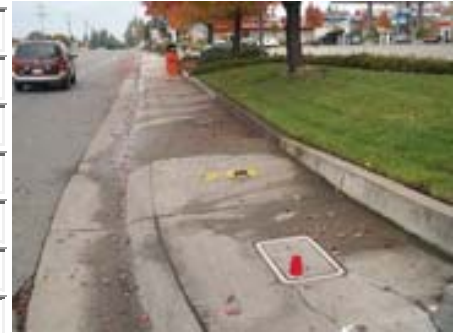
As Built Meas:	80	Quantity:	LF
Description:	Cross slope exceeds 2.0% (4.1% to 4.9%)		
As Built Desc:	4.5% cross slope		
Solution:	Demolish existing and construct new route		
Bar. Severity:	2 Recommended	Cost Estimate:	\$10,000.00
Implementation Priority:	1	Facility Function:	
Implementation Phase:		Implementation Date:	
Official Responsible:

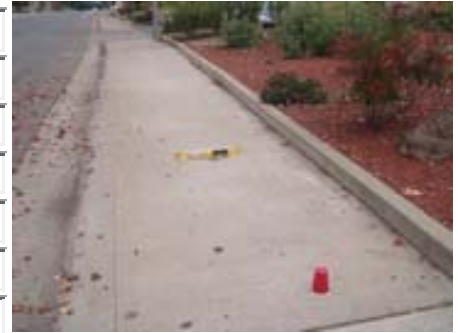
As Built Meas:	54	Quantity:	LF		
Description:	Cross slope exceeds 2.0% (4.1% to 4.9%)				
As Built Desc:	4.2% cross slope				
Solution:	Demolish existing and construct new route				
Bar. Severity:	2 Recommended	Cost Estimate:	\$6,750.00	Status:	
Implementation Priority:	1	Facility Function:			
Implementation Phase:		Implementation Date:			
Official Responsible:

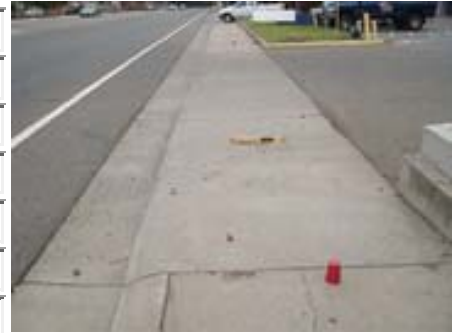
As Built Meas:	45	Quantity:	LF		
Description:	Driveway cross slope exceeds 2.0% (3.1% to 4.0%)				
As Built Desc:	3.3% cross slope				
Solution:	Provide min. 48" wide level walkway through driveway				
Bar. Severity:	2 Recommended	Cost Estimate:	\$5,625.00	Status:	
Implementation Priority:	1	Facility Function:			
Implementation Phase:		Implementation Date:			
Official Responsible:

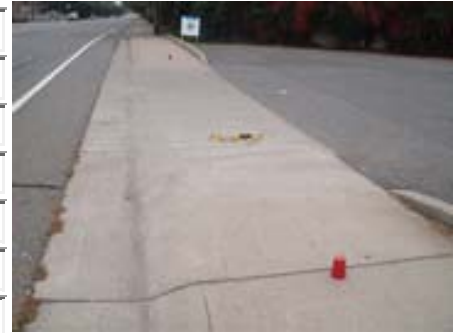
As Built Meas:	41	Quantity:	LF		
Description:	Driveway cross slope exceeds 2.0% (3.1% to 4.0%)				
As Built Desc:	3.9% cross slope				
Solution:	Provide min. 48" wide level walkway through driveway				
Bar. Severity:	2 Recommended	Cost Estimate:	\$5,125.00	Status:	
Implementation Priority:	1	Facility Function:			
Implementation Phase:		Implementation Date:			
Official Responsible:

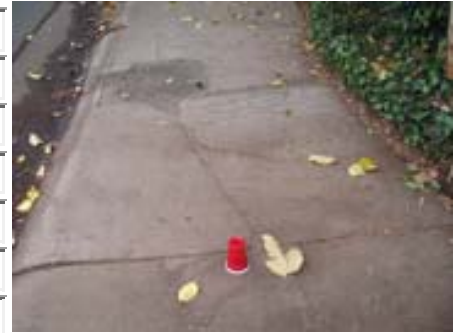
Field Date:	12/2/2010	Report Date:	12/2/2010	Barrier #:	3011B
Location:	Auburn Blvd - East				
X Coordinate:	-121.3159				
Y Coordinate:	38.68199				
Barrier Area:	Sidewalks				
Barrier Type:	Surface Condition - Damaged				
Code Ref:	CBC 1133B.7.1 and ADA/ABA 302.1

As Built Meas:	4	Quantity:	LF		
Description:	Surface is not firm and stable (cracked, broken or loose soil, etc.)				
As Built Desc:	Cracked concrete				
Solution:	Repair surface to make firm and stable				
Bar. Severity:	1 Necessary	Cost Estimate:	\$500.00	Status:	
Implementation Priority:	1	Facility Function:			
Implementation Phase:		Implementation Date:			
Official Responsible:

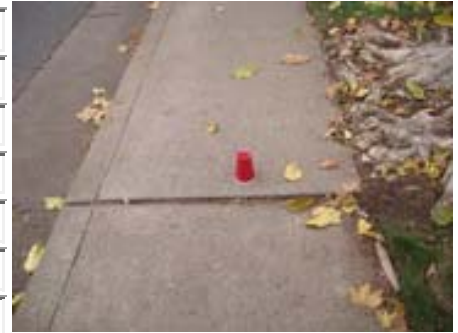
As Built Meas:	16	Quantity:	LF		
Description:	Change in level greater than 1/2"				
As Built Desc:	1/2" lip due to tree heaves				
Solution:	Grind or repair sidewalk to remove trip hazard				
Bar. Severity:	1 Necessary	Cost Estimate:	\$4,000.00	Status:	
Implementation Priority:	1	Facility Function:			
Implementation Phase:		Implementation Date:			
Official Responsible:

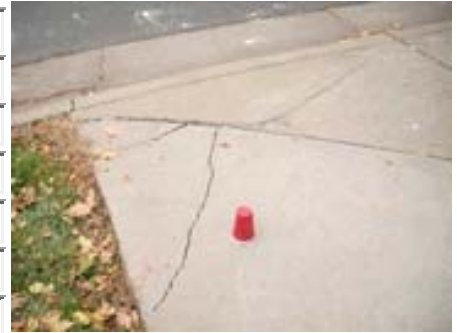
Field Date:	12/2/2010	Report Date:	12/2/2010	Barrier #:	3013D
Location:	Auburn Blvd - East				
X Coordinate:	-121.3151				
Y Coordinate:	38.6825				
Barrier Area:	Sidewalks				
Barrier Type:	Surface Condition - Damaged				
Code Ref:	CBC 1133B.7.1 and ADA/ABA 302.1

As Built Meas:	4	Quantity:	LF	
Description:	Surface is not firm and stable (cracked, broken or loose soil, etc.)			
As Built Desc:	Cracked concrete			
Solution:	Repair surface to make firm and stable			
Bar. Severity:	1 Necessary	Cost Estimate:	\$500.00	Status:
Implementation Priority:	1	Facility Function:		
Implementation Phase:		Implementation Date:		
Official Responsible:

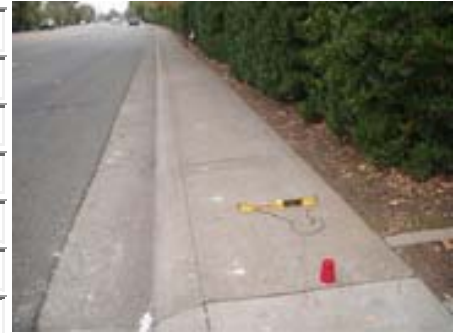
As Built Meas:	504	Quantity:	LF		
Description:	Cross slope exceeds 2.0% (4.1% to 4.9%)				
As Built Desc:	4.5% cross slope				
Solution:	Demolish existing and construct new route				
Bar. Severity:	2 Recommended	Cost Estimate:	\$63,000.00	Status:	
Implementation Priority:	1	Facility Function:			
Implementation Phase:		Implementation Date:			
Official Responsible:

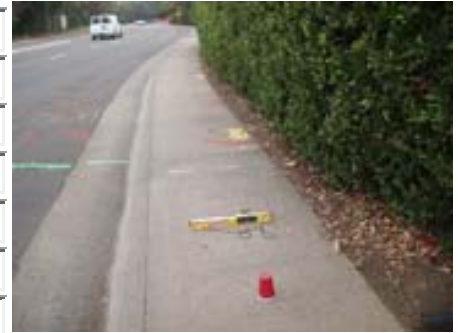
As Built Meas:	770	Quantity:	LF	
Description:	Cross slope exceeds 2.0% (4.1% to 4.9%)			
As Built Desc:	4.1% cross slope			
Solution:	Demolish existing and construct new route			
Bar. Severity:	2 Recommended	Cost Estimate:	\$96,250.00	Status:
Implementation Priority:	1	Facility Function:		
Implementation Phase:		Implementation Date:		
Official Responsible:

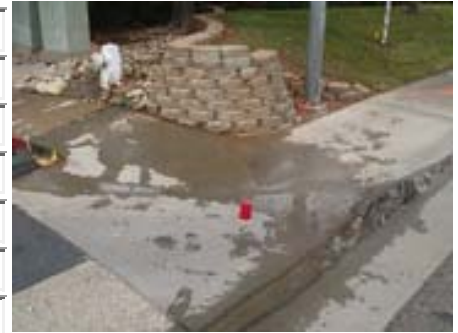
As Built Meas:	1	Quantity:	EACH	
Description:	No truncated domes provided at curb ramp			
As Built Desc:	No detectable warnings at curb ramp			
Solution:	Provide compliant truncated domes			
Bar. Severity:	2 Recommended	Cost Estimate:	\$0.00	Status:
Implementation Priority:	1	Facility Function:		
Implementation Phase:		Implementation Date:		
Official Responsible:

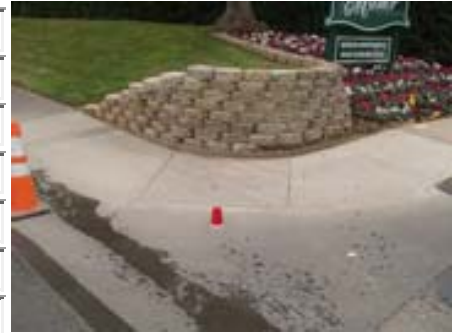
As Built Meas:	1	Quantity:	EACH		
Description:	No truncated domes provided at curb ramp				
As Built Desc:	No detectable warnings at curb ramp				
Solution:	Provide compliant truncated domes				
Bar. Severity:	2 Recommended	Cost Estimate:	\$0.00	Status:	
Implementation Priority:	1	Facility Function:			
Implementation Phase:		Implementation Date:			
Official Responsible:

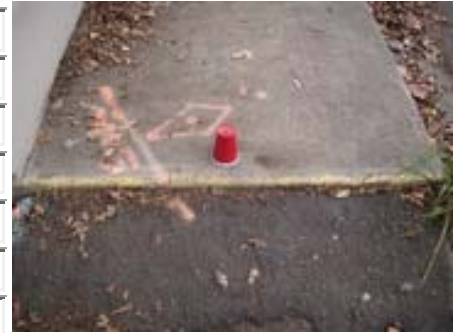
As Built Meas:	4	Quantity:	LF
Description:	Change in level greater than 1/2"		
As Built Desc:	1/2" lip in sidewalk surface		
Solution:	Grind or repair sidewalk to remove trip hazard		
Bar. Severity:	1 Necessary	Cost Estimate:	\$1,000.00
Implementation Priority:	1	Facility Function:	
Implementation Phase:		Implementation Date:	
Official Responsible:

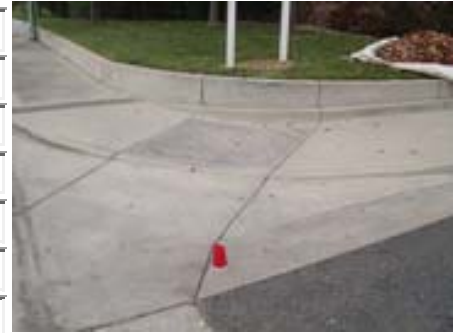
As Built Meas:	1	Quantity:	EACH	
Description:	No truncated domes provided at curb ramp			
As Built Desc:	No detectable warnings at curb ramp			
Solution:	Provide compliant truncated domes			
Bar. Severity:	2 Recommended	Cost Estimate:	\$0.00	Status:
Implementation Priority:	1	Facility Function:		
Implementation Phase:		Implementation Date:		
Official Responsible:

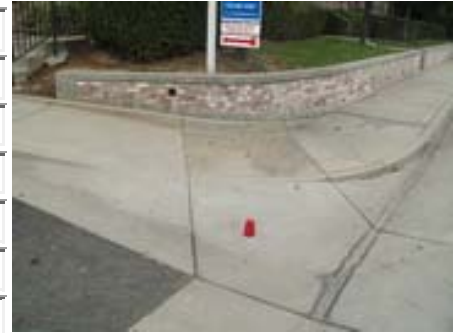
As Built Meas:	1	Quantity:	EACH		
Description:	No truncated domes provided at curb ramp				
As Built Desc:	No detectable warnings at curb ramp				
Solution:	Provide compliant truncated domes				
Bar. Severity:	2 Recommended	Cost Estimate:	\$0.00	Status:	
Implementation Priority:	1	Facility Function:			
Implementation Phase:		Implementation Date:			
Official Responsible:

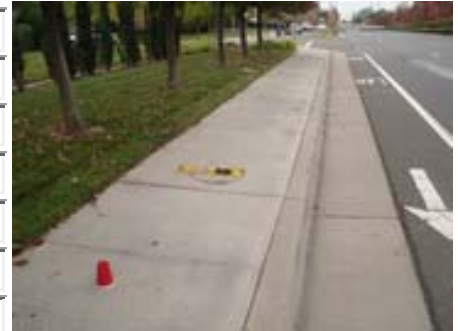
As Built Meas:	60	Quantity:	LF		
Description:	Cross slope exceeds 2.0% (4.1% to 4.9%)				
As Built Desc:	4.1% cross slope				
Solution:	Demolish existing and construct new route				
Bar. Severity:	2 Recommended	Cost Estimate:	\$7,500.00	Status:	
Implementation Priority:	1	Facility Function:			
Implementation Phase:		Implementation Date:			
Official Responsible:

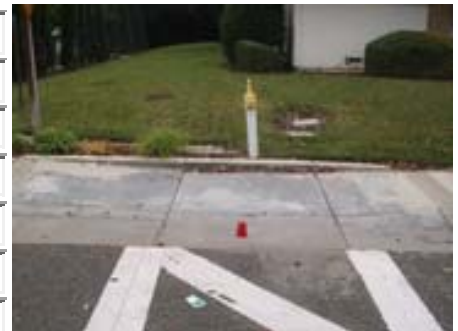
As Built Meas:	1	Quantity:	EACH		
Description:	12" grooves at top of curb ramp are not level (4.1% to 4.9%)				
As Built Desc:	4.2% at 12" grooves				
Solution:	Demolish existing and construct new curb ramp				
Bar. Severity:	2 Recommended	Cost Estimate:	\$2,500.00	Status:	
Implementation Priority:	1	Facility Function:			
Implementation Phase:		Implementation Date:			
Official Responsible:

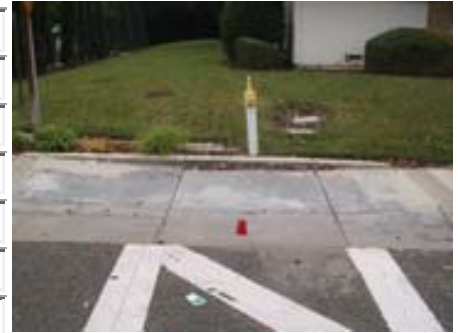
As Built Meas:	1	Quantity:	EACH	
Description:	No truncated domes provided at curb ramp			
As Built Desc:	No detectable warnings at curb ramp			
Solution:	Provide compliant truncated domes			
Bar. Severity:	2 Recommended	Cost Estimate:	\$0.00	Status:
Implementation Priority:	1	Facility Function:		
Implementation Phase:		Implementation Date:		
Official Responsible:

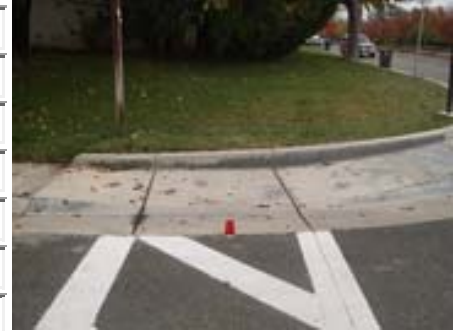
As Built Meas:	1	Quantity:	EACH		
Description:	No truncated domes provided at curb ramp				
As Built Desc:	No detectable warnings at curb ramp				
Solution:	Provide compliant truncated domes				
Bar. Severity:	2 Recommended	Cost Estimate:	\$0.00	Status:	
Implementation Priority:	1	Facility Function:			
Implementation Phase:		Implementation Date:			
Official Responsible:

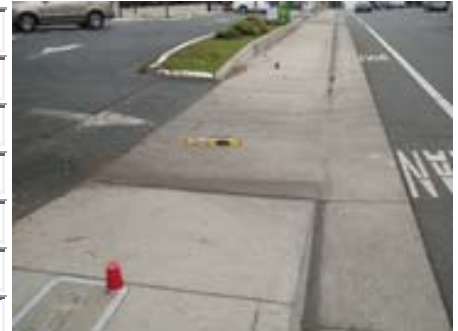
As Built Meas:	30	Quantity:	LF
Description:	Driveway cross slope exceeds 2.0% (3.1% to 4.0%)		
As Built Desc:	3.3% cross slope		
Solution:	Provide min. 48" wide level walkway through driveway		
Bar. Severity:	2 Recommended	Cost Estimate:	\$3,750.00
Implementation Priority:	1	Facility Function:	
Implementation Phase:		Implementation Date:	
Official Responsible:

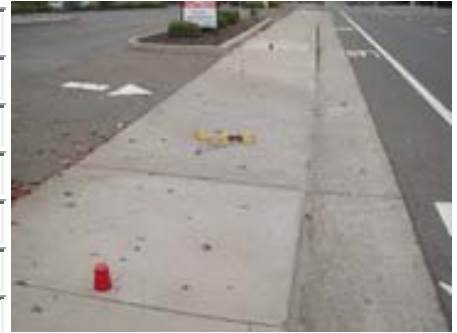
As Built Meas:	30	Quantity:	LF		
Description:	Driveway cross slope exceeds 2.0% (3.1% to 4.0%)				
As Built Desc:	3.8% cross slope				
Solution:	Provide min. 48" wide level walkway through driveway				
Bar. Severity:	2 Recommended	Cost Estimate:	\$3,750.00	Status:	
Implementation Priority:	1	Facility Function:			
Implementation Phase:		Implementation Date:			
Official Responsible:

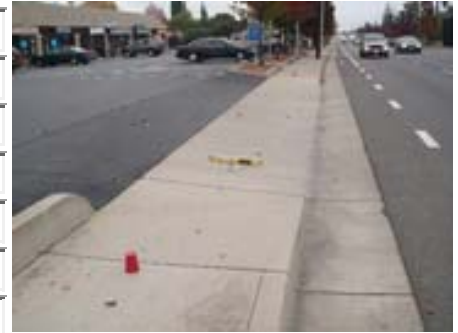
As Built Meas:	47	Quantity:	LF		
Description:	Driveway cross slope exceeds 2.0% (3.1% to 4.0%)				
As Built Desc:	3.6% cross slope				
Solution:	Provide min. 48" wide level walkway through driveway				
Bar. Severity:	2 Recommended	Cost Estimate:	\$5,875.00	Status:	
Implementation Priority:	1	Facility Function:			
Implementation Phase:		Implementation Date:			
Official Responsible:

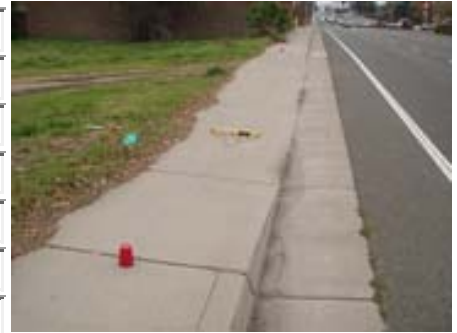
As Built Meas:	49	Quantity:	LF		
Description:	Driveway cross slope exceeds 2.0% (3.1% to 4.0%)				
As Built Desc:	3.2% cross slope				
Solution:	Provide min. 48" wide level walkway through driveway				
Bar. Severity:	2 Recommended	Cost Estimate:	\$6,125.00	Status:	
Implementation Priority:	1	Facility Function:			
Implementation Phase:		Implementation Date:			
Official Responsible:

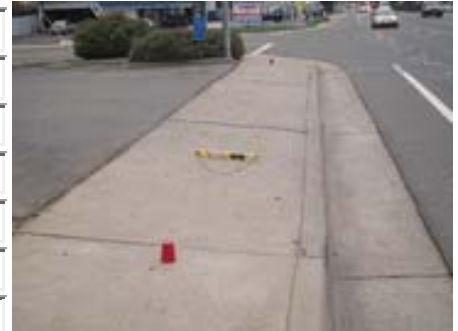
As Built Meas:	40	Quantity:	LF
Description:	Driveway cross slope exceeds 2.0% (5.0% or more)		
As Built Desc:	8.8% cross slope, 10.7% running slope at cracked concrete		
Solution:	Provide min. 48" wide level walkway through driveway		
Bar. Severity:	1 Necessary	Cost Estimate:	\$5,000.00
Implementation Priority:	1	Facility Function:	
Implementation Phase:		Implementation Date:	
Official Responsible:

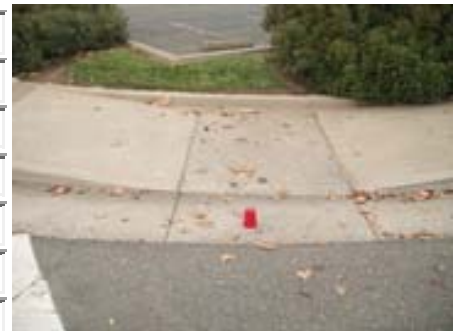
As Built Meas:	1	Quantity:	EACH	
Description:	Curb ramp landing or pan not level(4.1% to 4.9%)			
As Built Desc:	4.4% landing slope			
Solution:	Demolish existing and construct new transition			
Bar. Severity:	2 Recommended	Cost Estimate:	\$0.00	Status:
Implementation Priority:	1	Facility Function:		
Implementation Phase:		Implementation Date:		
Official Responsible:

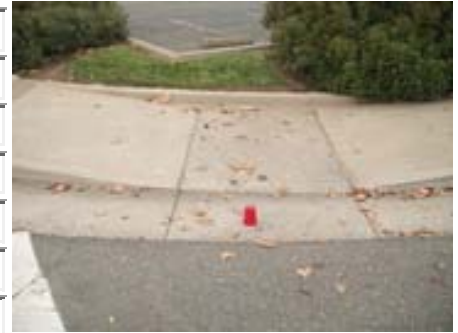
As Built Meas:	1	Quantity:	EACH		
Description:	No truncated domes provided at curb ramp				
As Built Desc:	No detectable warnings at curb ramp				
Solution:	Provide compliant truncated domes				
Bar. Severity:	2 Recommended	Cost Estimate:	\$0.00	Status:	
Implementation Priority:	1	Facility Function:			
Implementation Phase:		Implementation Date:			
Official Responsible:

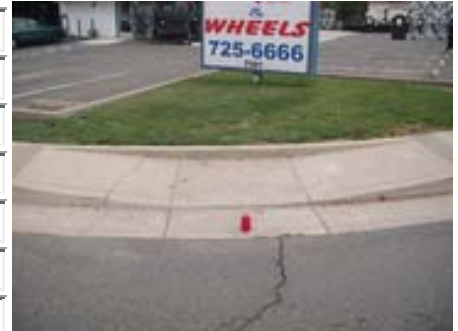
As Built Meas:	1	Quantity:	EACH		
Description:	Ramp run cross slope exceeds 2.0% (9.0% to 9.4%)				
As Built Desc:	9.3% running slope				
Solution:	Demolish existing and construct new curb ramp				
Bar. Severity:	2 Recommended	Cost Estimate:	\$0.00	Status:	
Implementation Priority:	1	Facility Function:			
Implementation Phase:		Implementation Date:			
Official Responsible:

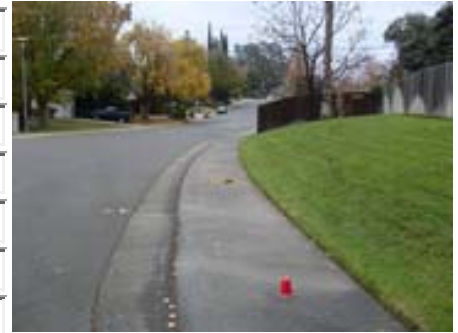
As Built Meas:	200	Quantity:	LF	
Description:	Cross slope exceeds 2.0% (4.1% to 4.9%)			
As Built Desc:	4.7% cross slope			
Solution:	Demolish existing and construct new route			
Bar. Severity:	2 Recommended	Cost Estimate:	\$25,000.00	Status:
Implementation Priority:	3	Facility Function:		
Implementation Phase:		Implementation Date:		
Official Responsible:

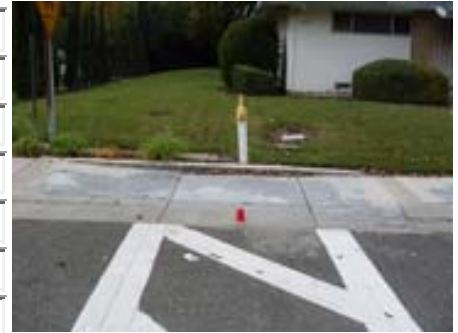
As Built Meas:	1	Quantity:	EACH	
Description:	No truncated domes provided at curb ramp			
As Built Desc:	No detectable warnings at curb ramp			
Solution:	Provide compliant truncated domes			
Bar. Severity:	2 Recommended	Cost Estimate:	\$0.00	Status:
Implementation Priority:	4	Facility Function:		
Implementation Phase:		Implementation Date:		
Official Responsible:

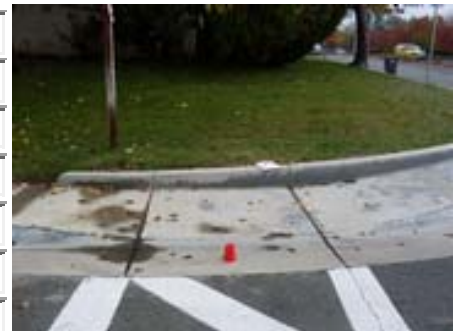
As Built Meas:	1	Quantity:	EACH	
Description:	12" grooves at top of curb ramp are not level (4.1% to 4.9%)			
As Built Desc:	4.1% at 12" grooves			
Solution:	Demolish existing and construct new curb ramp			
Bar. Severity:	2 Recommended	Cost Estimate:	\$2,500.00	Status:
Implementation Priority:	4	Facility Function:		
Implementation Phase:		Implementation Date:		
Official Responsible:

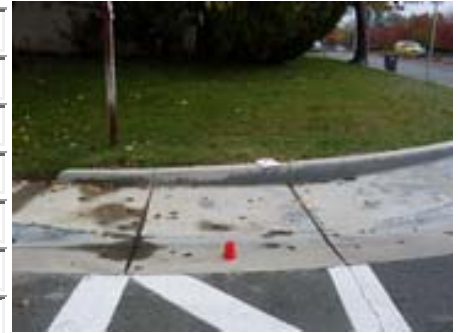
As Built Meas:	1	Quantity:	EACH	
Description:	No truncated domes provided at curb ramp			
As Built Desc:	No detectable warnings at curb ramp			
Solution:	Provide compliant truncated domes			
Bar. Severity:	2 Recommended	Cost Estimate:	\$0.00	Status:
Implementation Priority:	4	Facility Function:		
Implementation Phase:		Implementation Date:		
Official Responsible:

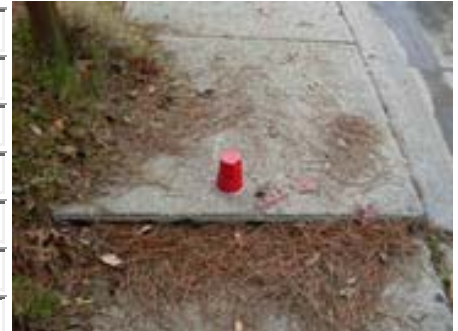
As Built Meas:	4	Quantity:	LF	
Description:	Change in level greater than 1/2"			
As Built Desc:	1" lip in sidewalk surface			
Solution:	Grind or repair sidewalk to remove trip hazard			
Bar. Severity:	1 Necessary	Cost Estimate:	\$1,000.00	Status:
Implementation Priority:	4	Facility Function:		
Implementation Phase:		Implementation Date:		
Official Responsible:

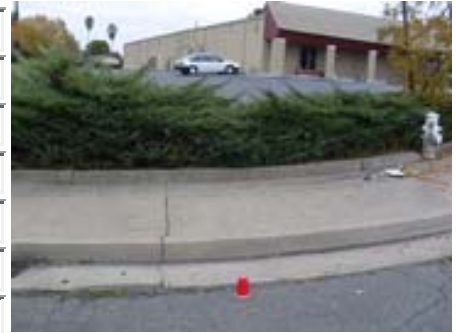
As Built Meas:	1	Quantity:	EACH		
Description:	No curb cut at corner (intersection)				
As Built Desc:	No curb ramp at corner				
Solution:	Demolish existing and construct curb cut				
Bar. Severity:	1 Necessary	Cost Estimate:	\$2,500.00	Status:	
Implementation Priority:	4	Facility Function:			
Implementation Phase:		Implementation Date:			
Official Responsible:

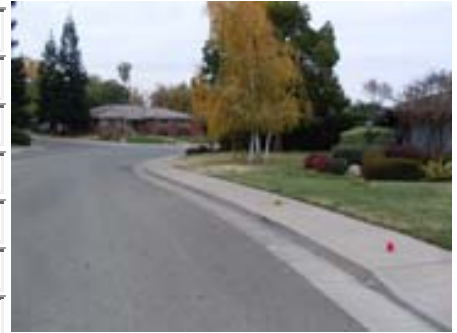
As Built Meas:	340	Quantity:	LF	
Description:	Cross slope exceeds 2.0% (4.1% to 4.9%)			
As Built Desc:	4.2% cross slope			
Solution:	Demolish existing and construct new route			
Bar. Severity:	2 Recommended	Cost Estimate:	\$42,500.00	Status:
Implementation Priority:	4	Facility Function:		
Implementation Phase:		Implementation Date:		
Official Responsible:

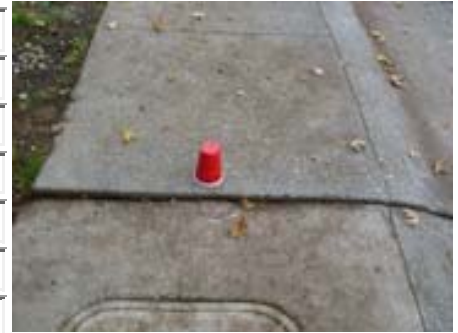
As Built Meas:	4	Quantity:	LF		
Description:	Change in level greater than 1/2"				
As Built Desc:	1/2" lip in sidewalk surface				
Solution:	Grind or repair sidewalk to remove trip hazard				
Bar. Severity:	1 Necessary	Cost Estimate:	\$1,000.00	Status:	
Implementation Priority:	4	Facility Function:			
Implementation Phase:		Implementation Date:			
Official Responsible:

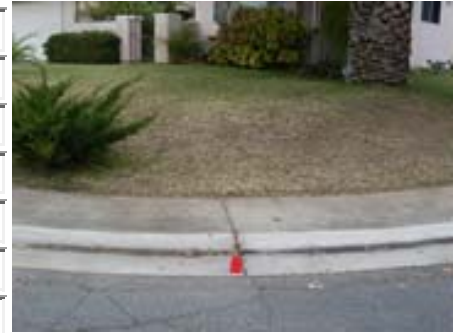
As Built Meas:	1	Quantity:	EACH	
Description:	No curb cut at corner (intersection)			
As Built Desc:	No curb ramp at corner			
Solution:	Demolish existing and construct curb cut			
Bar. Severity:	1 Necessary	Cost Estimate:	\$2,500.00	Status:
Implementation Priority:	3	Facility Function:		
Implementation Phase:		Implementation Date:		
Official Responsible:

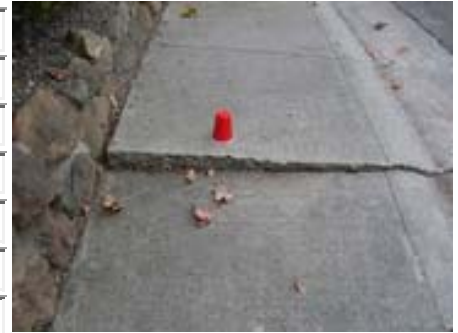
As Built Meas:	4	Quantity:	LF
Description:	Change in level greater than 1/2"		
As Built Desc:	2" lip in sidewalk surface		
Solution:	Grind or repair sidewalk to remove trip hazard		
Bar. Severity:	1 Necessary	Cost Estimate:	\$1,000.00
Implementation Priority:	4	Facility Function:	
Implementation Phase:		Implementation Date:	
Official Responsible:

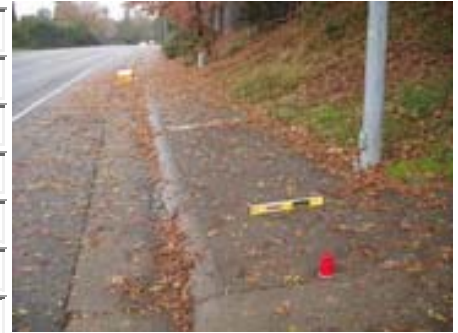
As Built Meas:	59	Quantity:	LF		
Description:	Cross slope exceeds 2.0% (4.1% to 4.9%)				
As Built Desc:	4.1% cross slope				
Solution:	Demolish existing and construct new route				
Bar. Severity:	2 Recommended	Cost Estimate:	\$7,375.00	Status:	
Implementation Priority:	1	Facility Function:			
Implementation Phase:		Implementation Date:			
Official Responsible:
