DRAFT ADA TRANSITION PLAN UPDATE
NEIGHBORHOOD AREA 9 SONA
SEPTEMBER 20, 2011

CITY OF CITRUS HEIGHTS

The Sunrise Oaks Neighborhood Association (SONA)

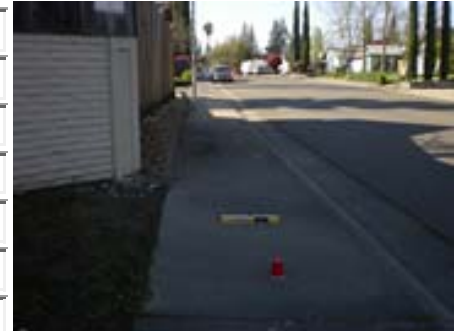
As Built Meas:	93	Quantity:	LF
Description:	Cross slope exceeds 2.0% (4.1% to 4.9%)		
As Built Desc:	4.5% cross slope		
Solution:	Demolish existing and construct new route		
Bar. Severity:	2 Recommended	Cost Estimate:	\$11,625.00
Implementation Priority:	4	Facility Function:	
Implementation Phase:		Implementation Date:	
Official Responsible:

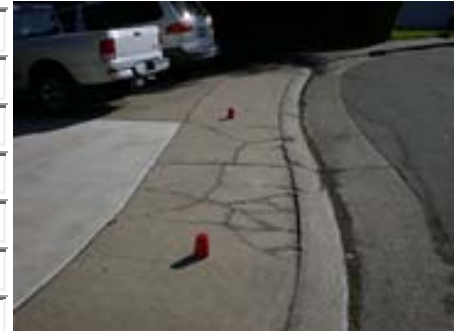
Field Date:	3/31/2011	Report Date:	3/31/2011	Barrier #:	6364B
Location:	Janquil Wy - North				
X Coordinate:	-121.2452				
Y Coordinate:	38.70004				
Barrier Area:	Sidewalks				
Barrier Type:	Surface Condition - Damaged				
Code Ref:	CBC 1133B.7.1 and ADA/ABA 302.1

As Built Meas:	8	Quantity:	LF
Description:	Surface is not firm and stable (cracked, broken or loose soil, etc.)		
As Built Desc:	Cracked concrete		
Solution:	Repair surface to make firm and stable		
Bar. Severity:	1 Necessary	Cost Estimate:	\$1,000.00
Implementation Priority:	4	Facility Function:	
Implementation Phase:		Implementation Date:	
Official Responsible:			
Notes:

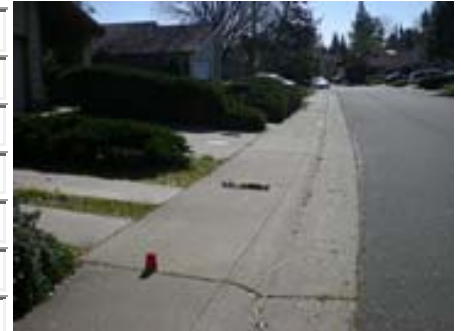
As Built Meas:	324	Quantity:	LF
Description:	Cross slope exceeds 2.0% (4.1% to 4.9%)		
As Built Desc:	4.7% cross slope		
Solution:	Demolish existing and construct new route		
Bar. Severity:	2 Recommended	Cost Estimate:	\$40,500.00
Implementation Priority:	4	Facility Function:	
Implementation Phase:		Implementation Date:	
Official Responsible:

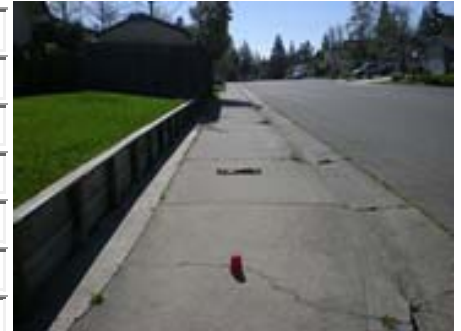
As Built Meas:	573	Quantity:	LF
Description:	Cross slope exceeds 2.0% (4.1% to 4.9%)		
As Built Desc:	4.2% cross slope		
Solution:	Demolish existing and construct new route		
Bar. Severity:	2 Recommended	Cost Estimate:	\$71,625.00
Implementation Priority:	4	Facility Function:	
Implementation Phase:		Implementation Date:	
Official Responsible:

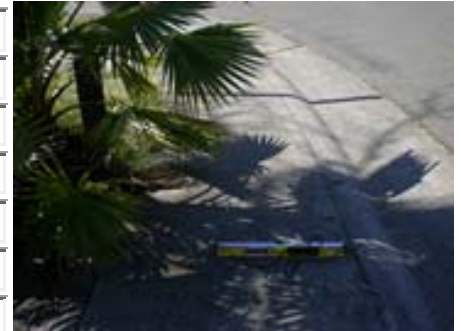
Field Date:	3/31/2011	Report Date:	3/31/2011	Barrier #:	6403B
Location:	Menke Wy Ct - East				
X Coordinate:	-121.24549				
Y Coordinate:	38.69683				
Barrier Area:	Sidewalks				
Barrier Type:	Protruding Hazard				
Code Ref:	CBC 1133B.8.6.1 and ADA/ABA 307.2

As Built Meas:	1	Quantity:	JOB
Description:	Protruding object in route of travel between 27" and 80" high		
As Built Desc:	17" at tree branch		
Solution:	Remove object or provide detectable warning		
Bar. Severity:	1 Necessary	Cost Estimate:	\$1,400.00
Implementation Priority:	4	Facility Function:	
Implementation Phase:		Implementation Date:	
Official Responsible:

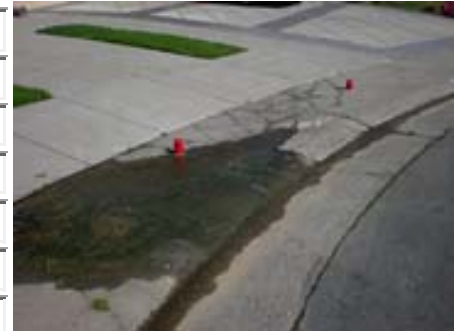
Barrier Type: Surface Condition - Damaged

As Built Meas: 8 Quantity: LF

Description: Surface is not firm and stable (cracked, broken or loose soil, etc.)

As Built Desc: Cracked concrete

Solution: Repair surface to make firm and stable

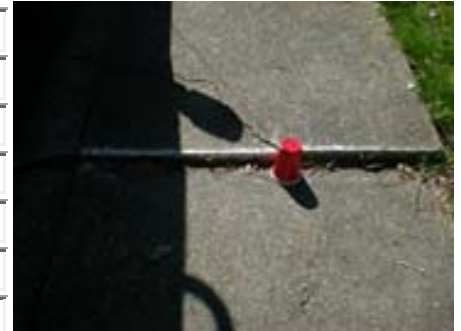
As Built Meas:	4	Quantity:	LF
Description:	Change in level greater than 1/2"		
As Built Desc:	1/2" lip in sidewalk surface		
Solution:	Grind or repair sidewalk to remove trip hazard		
Bar. Severity:	1 Necessary	Cost Estimate:	\$1,000.00
Implementation Priority:	4	Facility Function:	
Implementation Phase:		Implementation Date:	
Official Responsible:			
Notes:

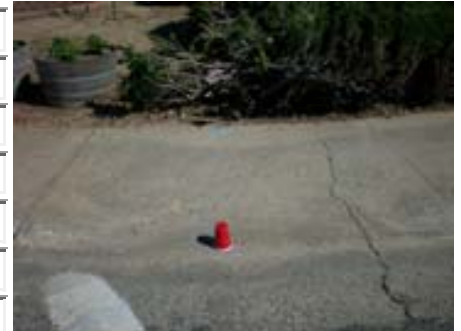
As Built Meas:	1	Quantity:	EACH
Description:	No compliant curb cut at corner (intersection)		
As Built Desc:	11.7% running slope at depressed area		
Solution:	Demolish existing and construct curb cut		
Bar. Severity:	1 Necessary	Cost Estimate:	\$2,500.00
Implementation Priority:	4	Facility Function:	
Implementation Phase:		Implementation Date:	
Official Responsible:			
Notes:	Two - way intersection corners B,C

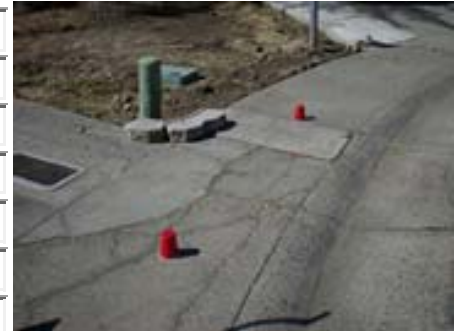
Field Date:	3/31/2011	Report Date:	3/31/2011	Barrier #:	6424B
Location:	Amsell Ct - South				
X Coordinate:	-121.24973				
Y Coordinate:	38.69848				
Barrier Area:	Sidewalks				
Barrier Type:	Surface Condition - Damaged				
Code Ref:	CBC 1133B.7.1 and ADA/ABA 302.1

As Built Meas:	4	Quantity:	LF
Description:	Surface is not firm and stable (cracked, broken or loose soil, etc.)		
As Built Desc:	Cracked concrete		
Solution:	Repair surface to make firm and stable		
Bar. Severity:	1 Necessary	Cost Estimate:	\$500.00
Implementation Priority:	4	Facility Function:	
Implementation Phase:		Implementation Date:	
Official Responsible:

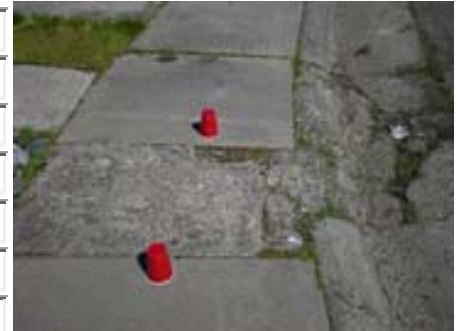
Field Date:	3/31/2011	Report Date:	3/31/2011	Barrier #:	6425B
Location:	Amsell Ct - North				
X Coordinate:	-121.24988				
Y Coordinate:	38.69858				
Barrier Area:	Sidewalks				
Barrier Type:	Surface Condition - Damaged				
Code Ref:	CBC 1133B.7.1 and ADA/ABA 302.1

As Built Meas:	4	Quantity:	LF
Description:	Surface is not firm and stable (cracked, broken or loose soil, etc.)		
As Built Desc:	Cracked concrete		
Solution:	Repair surface to make firm and stable		
Bar. Severity:	1 Necessary	Cost Estimate:	\$500.00
Implementation Priority:	4	Facility Function:	
Implementation Phase:		Implementation Date:	
Official Responsible:			
Notes:

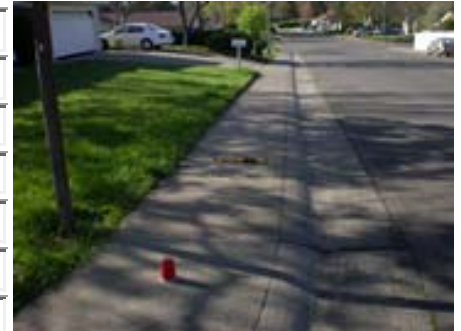
As Built Meas:	217	Quantity:	LF
Description:	Cross slope exceeds 2.0% (4.1% to 4.9%)		
As Built Desc:	4.8% cross slope		
Solution:	Demolish existing and construct new route		
Bar. Severity:	2 Recommended	Cost Estimate:	\$27,125.00
Implementation Priority:	3	Facility Function:	
Implementation Phase:		Implementation Date:	
Official Responsible:

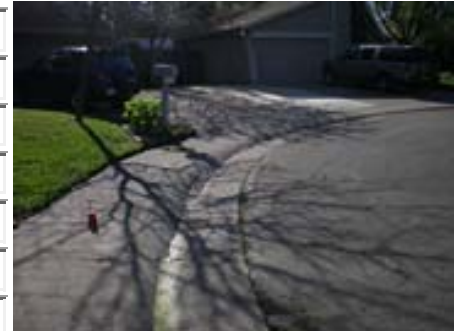
As Built Meas:	231	Quantity:	LF
Description:	Cross slope exceeds 2.0% (5.0% or more)		
As Built Desc:	6.1% cross slope		
Solution:	Demolish existing and construct new route		
Bar. Severity:	1 Necessary	Cost Estimate:	\$28,875.00
Implementation Priority:	4	Facility Function:	
Implementation Phase:		Implementation Date:	
Official Responsible:

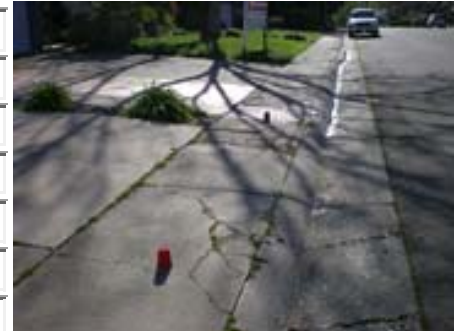
Barrier Type: Surface Condition - Damaged

As Built Meas: 12 Quantity: LF

Description: Surface is not firm and stable (cracked, broken or loose soil, etc.)

As Built Desc: Cracked concrete

Solution: Repair surface to make firm and stable

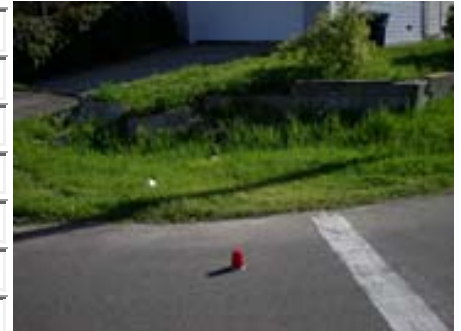
As Built Meas:	1	Quantity:	EACH
Description:	No truncated domes provided at transition into roadway		
As Built Desc:	No detectable warning		
Solution:	Provide compliant truncated domes		
Bar. Severity:	2 Recommended	Cost Estimate:	\$1,400.00
Implementation Priority:	4	Facility Function:	
Implementation Phase:		Implementation Date:	
Official Responsible:			
Notes:	Four - way intersection corners A, B, C, D

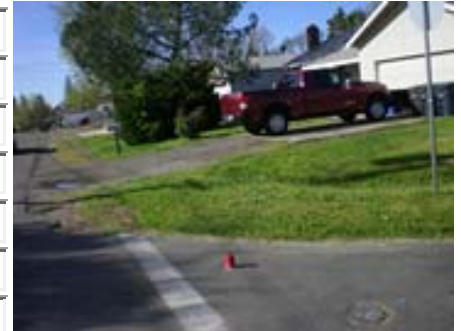
As Built Meas:	1	Quantity:	EACH
Description:	No truncated domes provided at transition into roadway		
As Built Desc:	No detectable warning		
Solution:	Provide compliant truncated domes		
Bar. Severity:	2 Recommended	Cost Estimate:	\$1,400.00
Implementation Priority:	4	Facility Function:	
Implementation Phase:		Implementation Date:	
Official Responsible:			
Notes:	Four - way intersection corners A, B, C, D

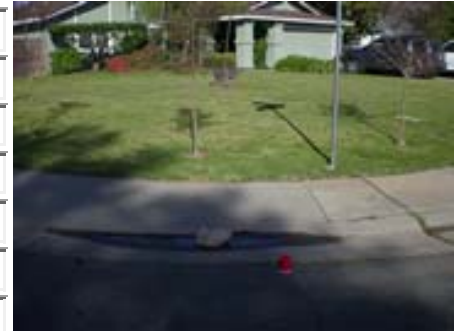
As Built Meas:	1	Quantity:	EACH
Description:	No compliant curb cut at corner (intersection)		
As Built Desc:	10.9% running slope at depressed area		
Solution:	Demolish existing and construct curb cut		
Bar. Severity:	1 Necessary	Cost Estimate:	\$2,500.00
Implementation Priority:	4	Facility Function:	
Implementation Phase:		Implementation Date:	
Official Responsible:

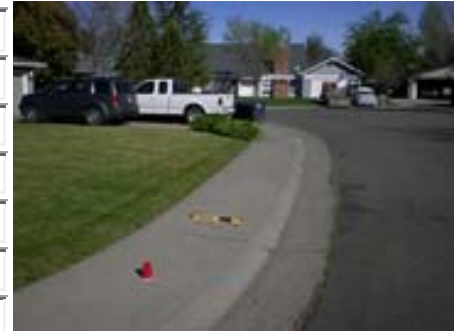
As Built Meas:	180	Quantity:	LF
Description:	Cross slope exceeds 2.0% (4.1% to 4.9%)		
As Built Desc:	4.5% cross slope		
Solution:	Demolish existing and construct new route		
Bar. Severity:	2 Recommended	Cost Estimate:	\$22,500.00
Implementation Priority:	4	Facility Function:	
Implementation Phase:		Implementation Date:	
Official Responsible:

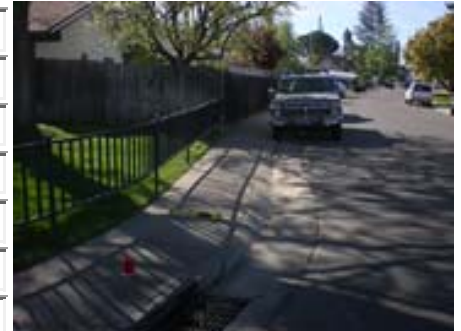
As Built Meas:	660	Quantity:	LF
Description:	Cross slope exceeds 2.0% (4.1% to 4.9%)		
As Built Desc:	4.7% cross slope		
Solution:	Demolish existing and construct new route		
Bar. Severity:	2 Recommended	Cost Estimate:	\$82,500.00
Implementation Priority:	4	Facility Function:	
Implementation Phase:		Implementation Date:	
Official Responsible:

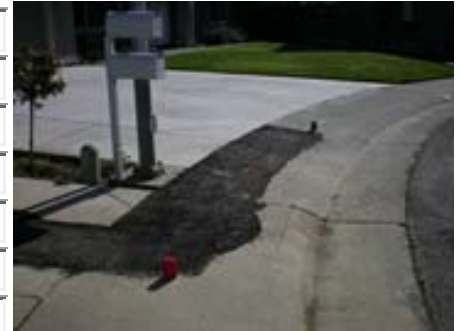
As Built Meas:	12	Quantity:	LF
Description:	Surface is not firm and stable (cracked, broken or loose soil, etc.)		
As Built Desc:	Cracked concrete		
Solution:	Repair surface to make firm and stable		
Bar. Severity:	1 Necessary	Cost Estimate:	\$1,500.00
Implementation Priority:	4	Facility Function:	
Implementation Phase:		Implementation Date:	
Official Responsible:			
Notes:

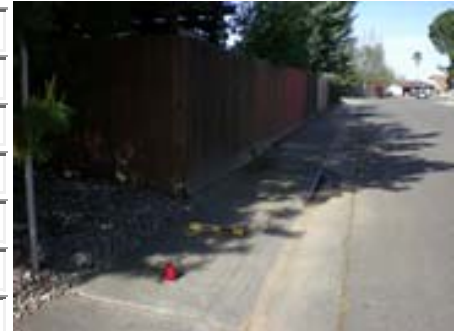
As Built Meas:	210	Quantity:	LF
Description:	Cross slope exceeds 2.0% (4.1% to 4.9%)		
As Built Desc:	4.8% cross slope		
Solution:	Demolish existing and construct new route		
Bar. Severity:	2 Recommended	Cost Estimate:	\$26,250.00
Status:			
Implementation Priority:	4	Facility Function:	
Implementation Phase:		Implementation Date:	
Official Responsible:

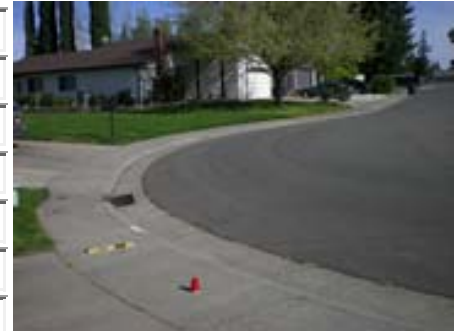
As Built Meas:	200	Quantity:	LF
Description:	Cross slope exceeds 2.0% (4.1% to 4.9%)		
As Built Desc:	4.4% cross slope		
Solution:	Demolish existing and construct new route		
Bar. Severity:	2 Recommended	Cost Estimate:	\$25,000.00
Implementation Priority:	4	Facility Function:	
Implementation Phase:		Implementation Date:	
Official Responsible:			
Notes:

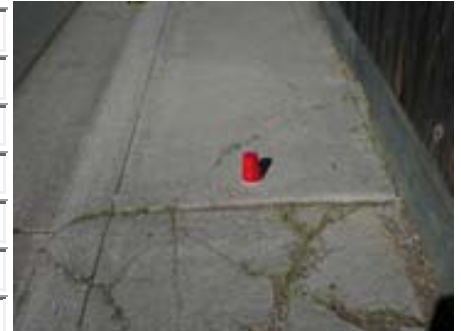
As Built Meas:	204	Quantity:	LF
Description:	Cross slope exceeds 2.0% (3.1% to 4.0%)		
As Built Desc:	4.0% cross slope		
Solution:	Demolish existing and construct new route		
Bar. Severity:	3 Hindrance	Cost Estimate:	\$25,500.00
Implementation Priority:	4	Facility Function:	
Implementation Phase:		Implementation Date:	
Official Responsible:			
Notes:

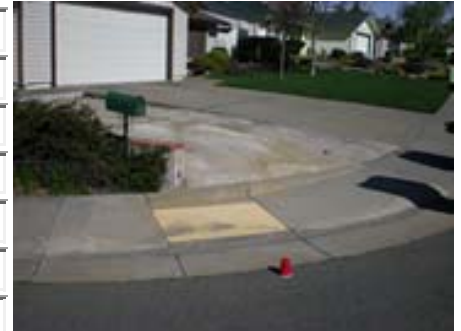
As Built Meas:	1	Quantity:	EACH
Description:	12" grooves at top of curb ramp are not level (4.1% to 4.9%)		
As Built Desc:	4.2% at 12" grooves		
Solution:	Demolish existing and construct new curb ramp		
Bar. Severity:	2 Recommended	Cost Estimate:	\$2,500.00
Implementation Priority:	4	Facility Function:	
Implementation Phase:		Implementation Date:	
Official Responsible:			
Notes:	Two - way intersection corners A,B. Corner B compliant

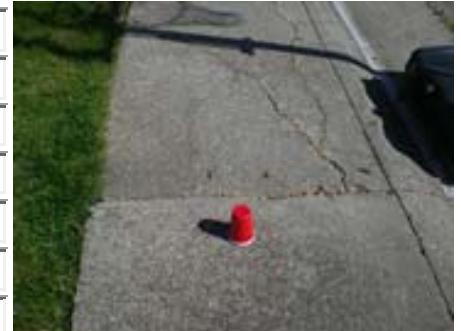
As Built Meas:	4	Quantity:	LF
Description:	Change in level greater than 1/2"		
As Built Desc:	1/2" lip in sidewalk surface		
Solution:	Grind or repair sidewalk to remove trip hazard		
Bar. Severity:	1 Necessary	Cost Estimate:	\$1,000.00
Implementation Priority:	4	Facility Function:	
Implementation Phase:		Implementation Date:	
Official Responsible:			
Notes:

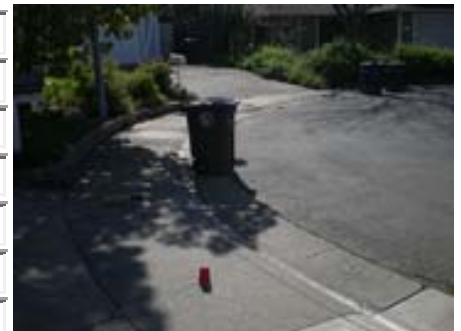
As Built Meas:	380	Quantity:	LF
Description:	Cross slope exceeds 2.0% (3.1% to 4.0%)		
As Built Desc:	3.9% cross slope		
Solution:	Demolish existing and construct new route		
Bar. Severity:	3 Hindrance	Cost Estimate:	\$47,500.00
Implementation Priority:	4	Facility Function:	
Implementation Phase:		Implementation Date:	
Official Responsible:			
Notes:

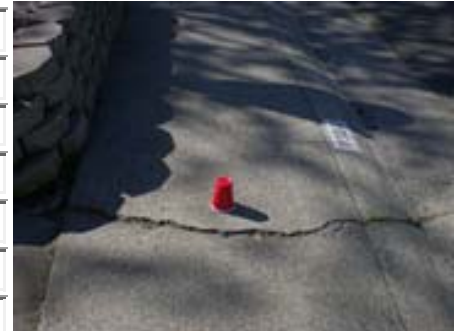
As Built Meas:	4	Quantity:	LF
Description:	Change in level greater than 1/2"		
As Built Desc:	1/2" lip in sidewalk surface		
Solution:	Grind or repair sidewalk to remove trip hazard		
Bar. Severity:	1 Necessary	Cost Estimate:	\$1,000.00
Implementation Priority:	4	Facility Function:	
Implementation Phase:		Implementation Date:	
Official Responsible:			
Notes:

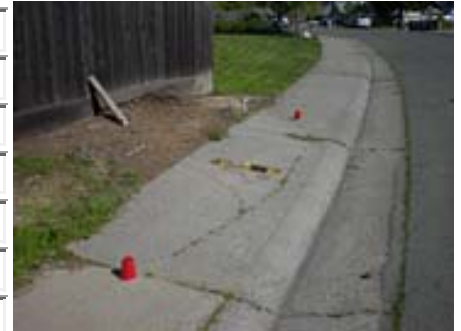
As Built Meas:	12	Quantity:	LF
Description:	Change in level greater than 1/2"		
As Built Desc:	1" lip due to tree heaves		
Solution:	Grind or repair sidewalk to remove trip hazard		
Bar. Severity:	1 Necessary	Cost Estimate:	\$3,000.00
Implementation Priority:	4	Facility Function:	
Implementation Phase:		Implementation Date:	
Official Responsible:			
Notes:

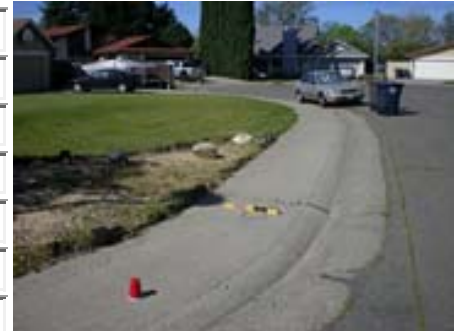
As Built Meas:	189	Quantity:	LF
Description:	Cross slope exceeds 2.0% (4.1% to 4.9%)		
As Built Desc:	4.1% cross slope		
Solution:	Demolish existing and construct new route		
Bar. Severity:	2 Recommended	Cost Estimate:	\$23,625.00
Implementation Priority:	4	Facility Function:	
Implementation Phase:		Implementation Date:	
Official Responsible:

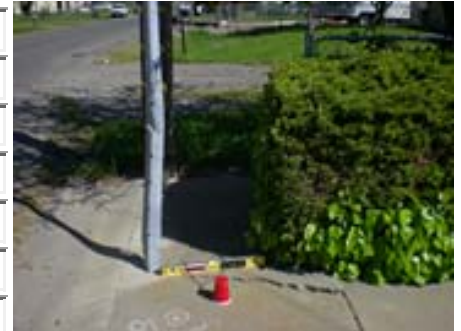
As Built Meas:	4	Quantity:	LF
Description:	Pedestrian route is not min. 48" wide ($\leq 31"$ or less)		
As Built Desc:	24" clear width due to guy wire		
Solution:	Replace guy wire or demolish existing and construct new route		
Bar. Severity:	1 Necessary	Cost Estimate:	\$500.00
Implementation Priority:	4	Facility Function:	
Implementation Phase:		Implementation Date:	
Official Responsible:

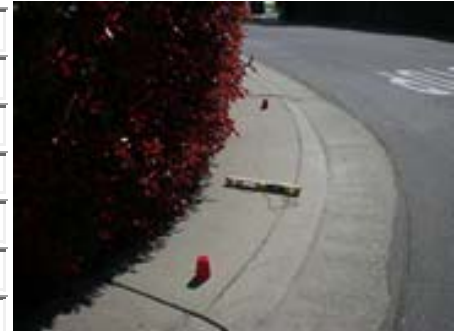
As Built Meas:	1	Quantity:	LF
Description:	Pedestrian route is not min. 48" wide ($\leq 31"$ or less)		
As Built Desc:	24" clear width due to foliage		
Solution:	Trim foliage to provide min. 48" clear width		
Bar. Severity:	1 Necessary	Cost Estimate:	\$125.00
Implementation Priority:	4	Facility Function:	
Implementation Phase:		Implementation Date:	
Official Responsible:			
Notes:

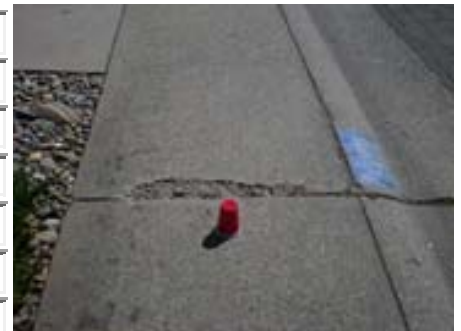
As Built Meas:	4	Quantity:	LF
Description:	Surface is not firm and stable (cracked, broken or loose soil, etc.)		
As Built Desc:	Cracked concrete		
Solution:	Repair surface to make firm and stable		
Bar. Severity:	1 Necessary	Cost Estimate:	\$500.00
Implementation Priority:	4	Facility Function:	
Implementation Phase:		Implementation Date:	
Official Responsible:			
Notes:

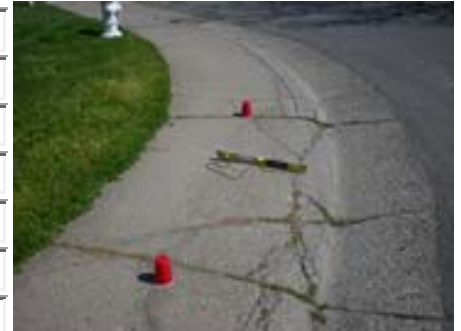
As Built Meas:	380	Quantity:	LF
Description:	Cross slope at elbow exceeds 2.0% (4.1% to 4.9%)		
As Built Desc:	4.7% cross slope		
Solution:	Demolish existing and construct new sidewalk without curb ramp		
Bar. Severity:	2 Recommended	Cost Estimate:	\$47,500.00
Implementation Priority:	4	Facility Function:	
Implementation Phase:		Implementation Date:	
Official Responsible:			
Notes:

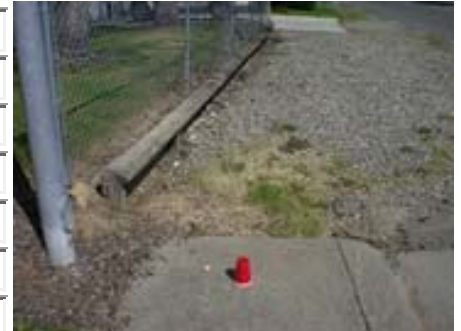
As Built Meas:	1	Quantity:	JOB
Description:	No barricade provided where sidewalk ends in hazardous location		
As Built Desc:	No barricade or other warning provided for the visually impaired at end of sidewalk		
Solution:	Provide barricade with cane detectable warning at end of sidewalk		
Bar. Severity:	1 Necessary	Cost Estimate:	\$1,350.00
Implementation Priority:	4	Facility Function:	
Implementation Phase:		Implementation Date:	
Official Responsible:			
Notes:

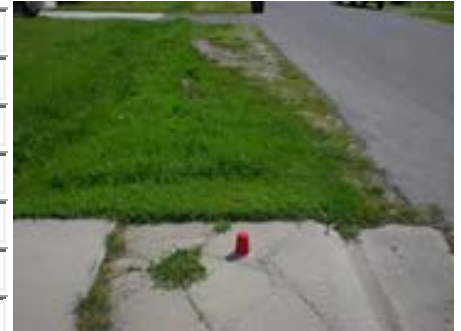
As Built Meas:	1	Quantity:	JOB
Description:	No barricade provided where sidewalk ends in hazardous location		
As Built Desc:	No barricade or other warning provided for the visually impaired at end of sidewalk		
Solution:	Provide barricade with cane detectable warning at end of sidewalk		
Bar. Severity:	1 Necessary	Cost Estimate:	\$1,350.00
Implementation Priority:	4	Facility Function:	
Implementation Phase:		Implementation Date:	
Official Responsible:

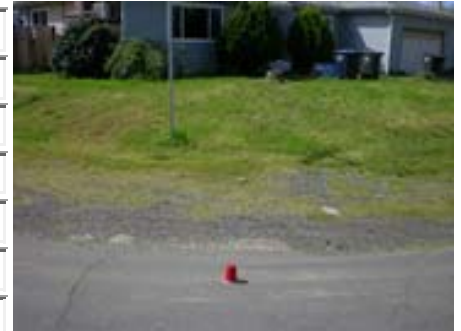
As Built Meas:	1	Quantity:	EACH
Description:	No truncated domes provided at transition into roadway		
As Built Desc:	No detectable warning provided		
Solution:	Provide compliant truncated domes		
Bar. Severity:	2 Recommended	Cost Estimate:	\$1,400.00
Implementation Priority:	4	Facility Function:	
Implementation Phase:		Implementation Date:	
Official Responsible:			
Notes:	Two - way intersection corners A,D

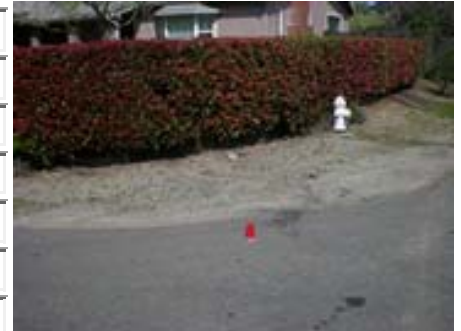
As Built Meas:	1	Quantity:	EACH
Description:	No truncated domes provided at transition into roadway		
As Built Desc:	No detectable warning provided		
Solution:	Provide compliant truncated domes		
Bar. Severity:	2 Recommended	Cost Estimate:	\$1,400.00
Implementation Priority:	4	Facility Function:	
Implementation Phase:		Implementation Date:	
Official Responsible:			
Notes:	Two - way intersection corners A,D

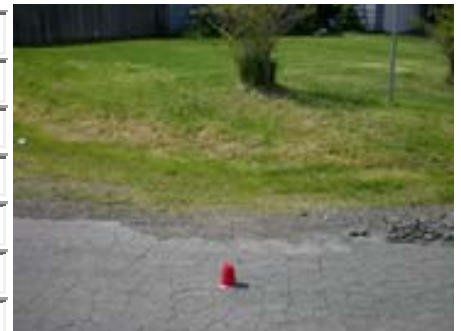
As Built Meas:	1	Quantity:	EACH
Description:	No truncated domes provided at transition into roadway		
As Built Desc:	No detectable warning provided		
Solution:	Provide compliant truncated domes		
Bar. Severity:	2 Recommended	Cost Estimate:	\$1,400.00
Implementation Priority:	4	Facility Function:	
Implementation Phase:		Implementation Date:	
Official Responsible:			
Notes:	Two - way intersection corners A,D

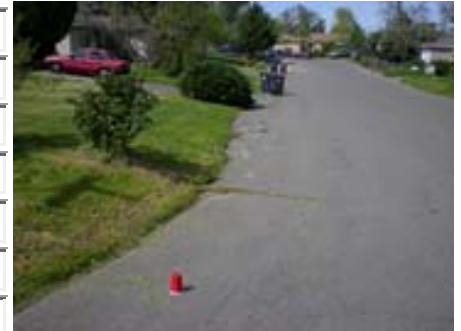
As Built Meas:	285	Quantity:	LF
Description:	No pedestrian route provided		
As Built Desc:	No sidewalk provided		
Solution:	Construct new firm and stable pedestrian route		
Bar. Severity:	1 Necessary	Cost Estimate:	\$28,500.00
Implementation Priority:	4	Facility Function:	
Implementation Phase:		Implementation Date:	
Official Responsible:

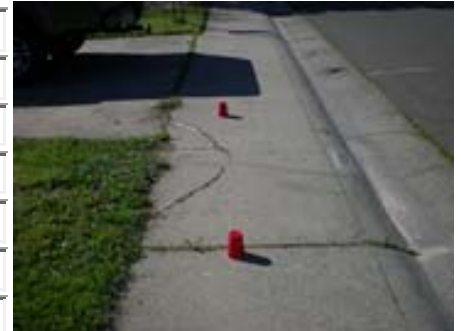
As Built Meas:	4	Quantity:	LF
Description:	Surface is not firm and stable (cracked, broken or loose soil, etc.)		
As Built Desc:	Cracked concrete		
Solution:	Repair surface to make firm and stable		
Bar. Severity:	1 Necessary	Cost Estimate:	\$500.00
Implementation Priority:	4	Facility Function:	
Implementation Phase:		Implementation Date:	
Official Responsible:			
Notes:

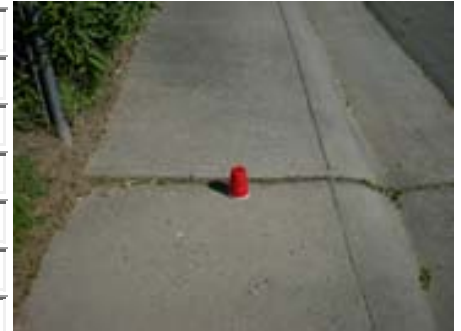
As Built Meas:	4	Quantity:	LF
Description:	Change in level greater than 1/2"		
As Built Desc:	1/2" lip in sidewalk surface		
Solution:	Grind or repair sidewalk to remove trip hazard		
Bar. Severity:	1 Necessary	Cost Estimate:	\$1,000.00
Implementation Priority:	4	Facility Function:	
Implementation Phase:		Implementation Date:	
Official Responsible:			
Notes:

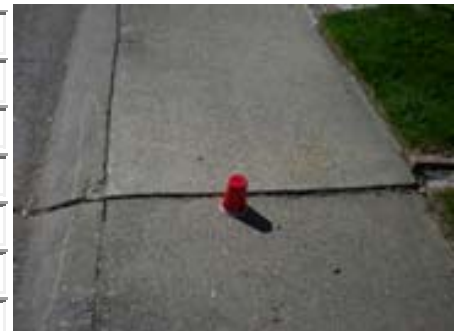
As Built Meas:	4	Quantity:	LF
Description:	Change in level greater than 1/2"		
As Built Desc:	1/2" lip in sidewalk surface		
Solution:	Grind or repair sidewalk to remove trip hazard		
Bar. Severity:	1 Necessary	Cost Estimate:	\$1,000.00
Implementation Priority:	4	Facility Function:	
Implementation Phase:		Implementation Date:	
Official Responsible:			
Notes:

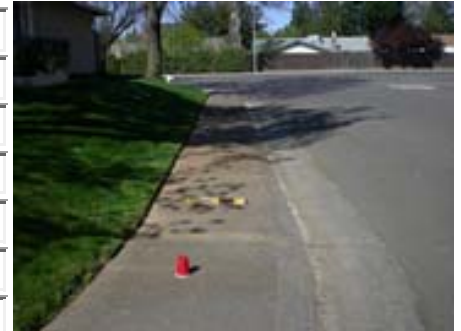
As Built Meas:	78	Quantity:	LF
Description:	Cross slope exceeds 2.0% (4.1% to 4.9%)		
As Built Desc:	4.4% cross slope		
Solution:	Demolish existing and construct new route		
Bar. Severity:	2 Recommended	Cost Estimate:	\$9,750.00
Implementation Priority:	4	Facility Function:	
Implementation Phase:		Implementation Date:	
Official Responsible:			
Notes:

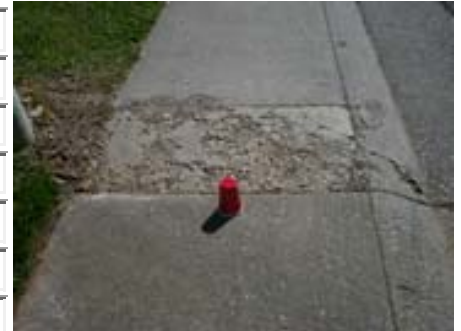
As Built Meas:	4	Quantity:	LF
Description:	Surface is not firm and stable (cracked, broken or loose soil, etc.)		
As Built Desc:	Cracked concrete		
Solution:	Repair surface to make firm and stable		
Bar. Severity:	1 Necessary	Cost Estimate:	\$500.00
Implementation Priority:	4	Facility Function:	
Implementation Phase:		Implementation Date:	
Official Responsible:			
Notes:

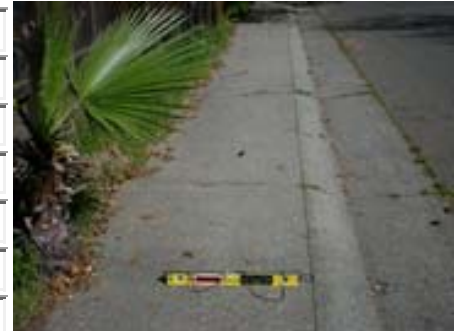
As Built Meas:	1	Quantity:	JOB
Description:	Protruding object in route of travel between 27" and 80" high		
As Built Desc:	27" at tree branch		
Solution:	Remove object or provide detectable warning		
Bar. Severity:	1 Necessary	Cost Estimate:	\$1,400.00
Implementation Priority:	4	Facility Function:	
Implementation Phase:		Implementation Date:	
Official Responsible:			
Notes:

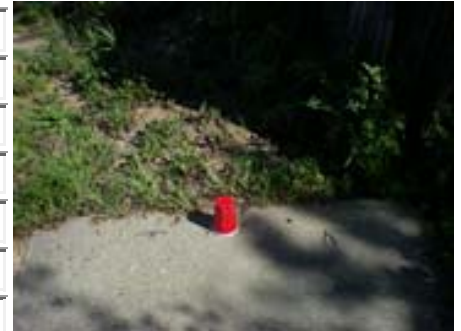
As Built Meas:	1	Quantity:	JOB
Description:	No barricade provided where sidewalk ends in hazardous location		
As Built Desc:	No barricade or other warning provided for the visually impaired at end of sidewalk		
Solution:	Provide barricade with cane detectable warning at end of sidewalk		
Bar. Severity:	1 Necessary	Cost Estimate:	\$1,350.00
Implementation Priority:	4	Facility Function:	
Implementation Phase:		Implementation Date:	
Official Responsible:			
Notes:

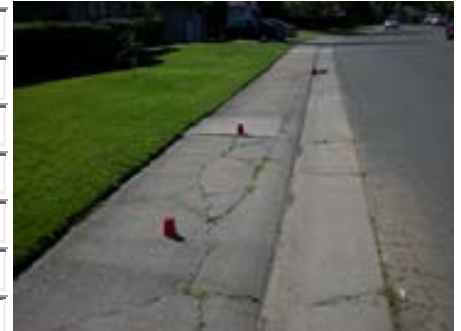
As Built Meas:	8	Quantity:	LF
Description:	Surface is not firm and stable (cracked, broken or loose soil, etc.)		
As Built Desc:	Cracked concrete		
Solution:	Repair surface to make firm and stable		
Bar. Severity:	1 Necessary	Cost Estimate:	\$1,000.00
Implementation Priority:	4	Facility Function:	
Implementation Phase:		Implementation Date:	
Official Responsible:

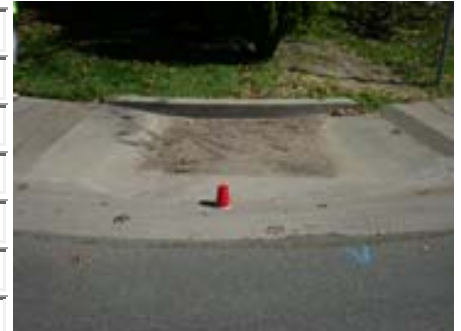
As Built Meas:	1	Quantity:	EACH
Description:	No truncated domes provided at curb ramp		
As Built Desc:	No detectable warnings at curb ramp		
Solution:	Provide compliant truncated domes		
Bar. Severity:	2 Recommended	Cost Estimate:	\$1,400.00
Implementation Priority:	4	Facility Function:	
Implementation Phase:		Implementation Date:	
Official Responsible:

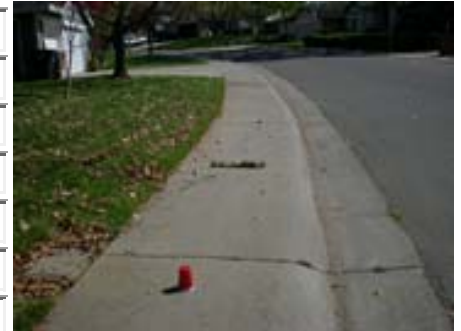
As Built Meas:	345	Quantity:	LF
Description:	Cross slope exceeds 2.0% (4.1% to 4.9%)		
As Built Desc:	4.5% cross slope		
Solution:	Demolish existing and construct new route		
Bar. Severity:	2 Recommended	Cost Estimate:	\$43,125.00
Implementation Priority:	4	Facility Function:	
Implementation Phase:		Implementation Date:	
Official Responsible:

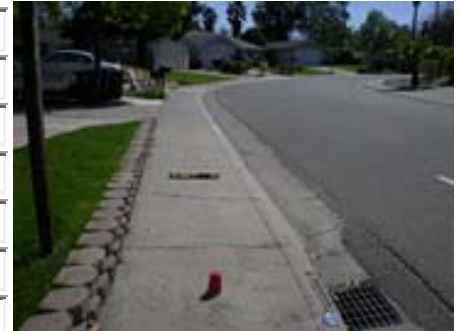
As Built Meas:	257	Quantity:	LF
Description:	Cross slope exceeds 2.0% (4.1% to 4.9%)		
As Built Desc:	4.8% cross slope		
Solution:	Demolish existing and construct new route		
Bar. Severity:	2 Recommended	Cost Estimate:	\$32,125.00
Implementation Priority:	4	Facility Function:	
Implementation Phase:		Implementation Date:	
Official Responsible:			
Notes:
