CITY OF CITRUS HEIGHTS

DRAFT ADA TRANSITION PLAN UPDATE

NEIGHBORHOOD AREA 2 RUSCH PARK

SEPTEMBER 20, 2011

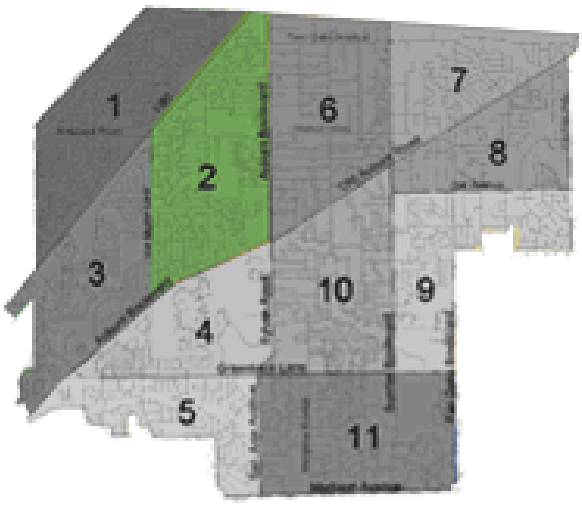
Built elements found within the public rights-of-way in the Rusch Park Neighborhood Area were "depressed curbs" which are not actual curb cuts but depressed areas in the concrete at intersection corners that it is assumed were intended to assist with travel over the existing vertical or rolled curb. Also, a number of locations were identified with "elbows" that were altered into curb ramps. These locations are in residential areas, in which 90 degree turns in the sidewalk were actually altered into curb ramps without a crossing through the roadway that the curb ramp would be intended to enable.

It is assumed that an error was made in the design or construction process that led to this issue, as the sidewalk at such locations is not required to have a curb cut or ramp, as it is not a safe location to encourage crossing due to the lack of line of sight for on-coming cars and due to the fact that this area constitutes the longest route of travel through the roadway at a crossing within the residential areas. A curb ramp at such a location actually makes pedestrian travel more difficult.

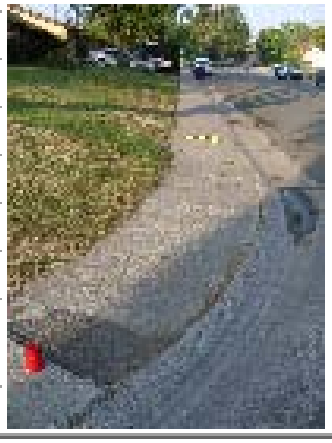
Field Date: 10/20/2010 Report Date: 10/20/2010 Barrier #: 1048A

Location: Oak Spring Wy - South
X Coordinate: -121.30492
Y Coordinate: 38.70863
Barrier Area: Sidewalks
Barrier Type: Cross Slope - Existing (5.0% or more)
Code Ref: CBC 1133B.7.1 and ADA/ABA 303.3
As Built Meas: 504 Quantity: LF
Description: Cross slope exceeds 2.0% (5.0% or more)
As Built Desc: 8.2% cross slope
Solution: Demolish existing and construct new route
Bar. Severity: 1 Necessary Cost Estimate: $63,000.00 Status:
Implementation Priority: 4 Facility Function:
Implementation Phase: Implementation Date:
Official Responsible:
Notes:

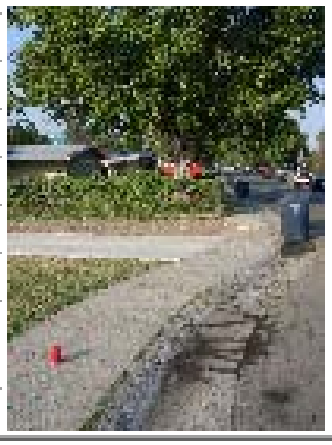
Field Date: 10/20/2010 Report Date: 10/20/2010 Barrier #: 1053A

Location: Birchwood Cir - South
X Coordinate: -121.30498
Y Coordinate: 38.70788
Barrier Area: Sidewalks
Barrier Type: Cross Slope - Existing (5.0% or more)
Code Ref: CBC 1133B.7.1 and ADA/ABA 303.3
As Built Meas: 783 Quantity: LF
Description: Cross slope exceeds 2.0% (5.0% or more)
As Built Desc: 9.3% cross slope
Solution: Demolish existing and construct new route
Bar. Severity: 1 Necessary Cost Estimate: $97,875.00 Status:
Implementation Priority: 4 Facility Function:
Implementation Phase: Implementation Date:
Official Responsible:
Notes:

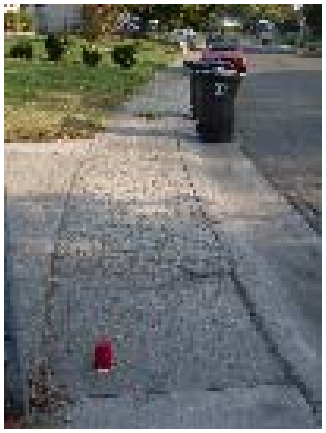
Field Date: 10/20/2010 Report Date: 10/20/2010 Barrier #: 1054A

Location: Birchwood Cir - West
X Coordinate: -121.30741
Y Coordinate: 38.7083
Barrier Area: Sidewalks
Barrier Type: Cross Slope - Existing (5.0% or more)
Code Ref: CBC 1133B.7.1 and ADA/ABA 303.3
As Built Meas: 413 Quantity: LF
Description: Cross slope exceeds 2.0% (5.0% or more)
As Built Desc: 5.7% cross slope
Solution: Demolish existing and construct new route
Bar. Severity: 1 Necessary Cost Estimate: $51,625.00 Status:
Implementation Priority: 4 Facility Function:
Implementation Phase: Implementation Date:
Official Responsible:
Notes:

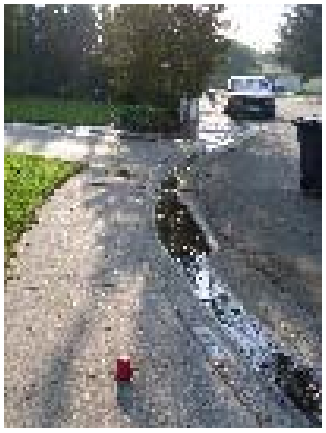
Field Date: 10/20/2010 Report Date: 10/20/2010 Barrier #: 1054C
Location: Birchwood Cir - West
X Coordinate: -121.30717
Y Coordinate: 38.70854
Barrier Area: Sidewalks
Barrier Type: Abrupt Change in Level - > 1/2"
Code Ref: CBC 1133B.7.1 and ADA/ABA 303.3
As Built Meas: 4 Quantity: LF
Description: Change in level greater than 1/2"
As Built Desc: 1" lip in sidewalk surface
Solution: Grind or repair sidewalk to remove trip hazard
Bar. Severity: 1 Necessary Cost Estimate: $1,000.00 Status:
Implementation Priority: 4 Facility Function:
Implementation Phase: Implementation Date:
Official Responsible:
Notes:

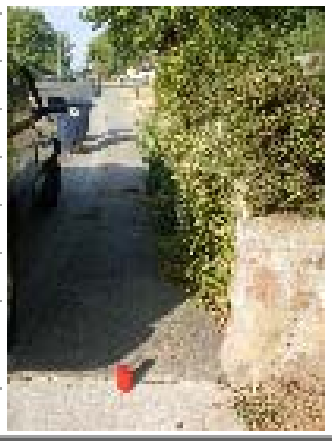
Field Date: 10/20/2010 Report Date: 10/20/2010 Barrier #: 1059B

Location: Gumwood Cir - North
X Coordinate: -121.30352
Y Coordinate: 38.7093
Barrier Area: Sidewalks
Barrier Type: Clear Width - Existing (≤31" or less)
Code Ref: CBC 1133B.7.1
As Built Meas: 28 Quantity: LF
Description: Pedestrian route is not min. 48" wide (≤31" or less)
As Built Desc: 24" clear width due to foliage
Solution: Trim foliage to provide min. 48" clear width
Bar. Severity: 1 Necessary Cost Estimate: $0.00 Status:
Implementation Priority: 4 Facility Function:
Implementation Phase: Implementation Date:
Official Responsible:
Notes:

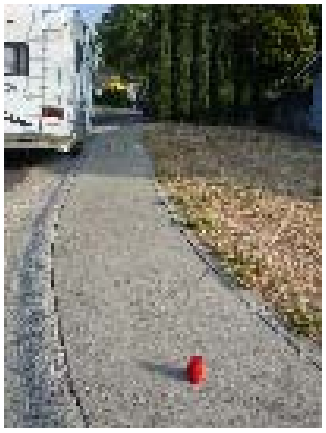
Field Date: 10/20/2010 Report Date: 10/20/2010 Barrier #: 1062A

Location: Picnic Cr - East
X Coordinate: -121.30455
Y Coordinate: 38.70938
Barrier Area: Sidewalks
Barrier Type: Cross Slope - Existing (5.0% or more)
Code Ref: CBC 1133B.7.1 and ADA/ABA 303.3
As Built Meas: 331 Quantity: LF
Description: Cross slope exceeds 2.0% (5.0% or more)
As Built Desc: 8.3% cross slope
Solution: Demolish existing and construct new route
Bar. Severity: 1 Necessary Cost Estimate: $41,375.00 Status:
Implementation Priority: 4 Facility Function:
Implementation Phase: Implementation Date:
Official Responsible:
Notes:

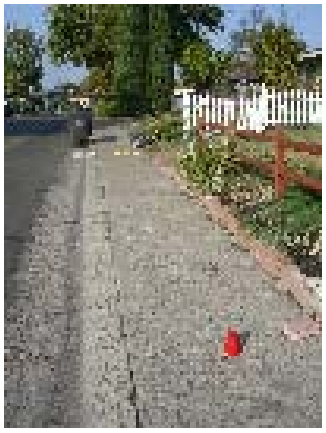
Field Date:	10/20/2010
Report Date:	10/20/2010
Barrier #:	1063C
Location:	Pine Ct - West
X Coordinate:	-121.30436
Y Coordinate:	38.70997
Barrier Area:	Sidewalks
Barrier Type:	Abrupt Change in Level - > 1/2"
Code Ref:	CBC 1133B.7.1 and ADA/ABA 303.3
As Built Meas:	4
Quantity:	LF
Description:	Change in level greater than 1/2"
As Built Desc:	1" lip in sidewalk surface
Solution:	Grind or repair sidewalk to remove trip hazard
Bar. Severity:	1 Necessary
Cost Estimate:	$1,000.00
Status:	
Implementation Priority:	4
Facility Function:	
Implementation Phase:	
Implementation Date:	
Official Responsible:	
Notes:

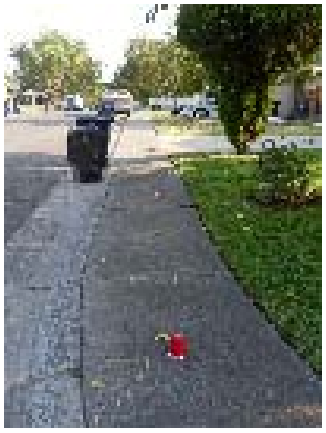
Field Date: 10/20/2010 Report Date: 10/20/2010 Barrier #: 1065A

Location: Gumwood Cir - East
X Coordinate: -121.30549
Y Coordinate: 38.70943
Barrier Area: Sidewalks
Barrier Type: Cross Slope - Existing (5.0% or more)
Code Ref: CBC 1133B.7.1 and ADA/ABA 303.3
As Built Meas: 590 Quantity: LF
Description: Cross slope exceeds 2.0% (5.0% or more)
As Built Desc: 6.6% cross slope
Solution: Demolish existing and construct new route
Bar. Severity: 1 Necessary Cost Estimate: $73,750.00 Status:
Implementation Priority: 4 Facility Function:
Implementation Phase: Implementation Date:
Official Responsible:
Notes:

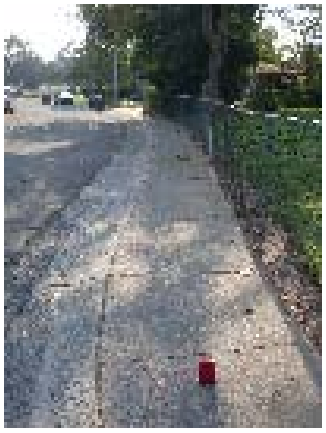
Field Date: 10/20/2010 Report Date: 10/20/2010 Barrier #: 1066A

Location: Gumwood Cir - East
X Coordinate: -121.30568
Y Coordinate: 38.7097
Barrier Area: Sidewalks
Barrier Type: Cross Slope - Existing (5.0% or more)
Code Ref: CBC 1133B.7.1 and ADA/ABA 303.3
As Built Meas: 270 Quantity: LF
Description: Cross slope exceeds 2.0% (5.0% or more)
As Built Desc: 5.4% cross slope
Solution: Demolish existing and construct new route
Bar. Severity: 1 Necessary Cost Estimate: $33,750.00 Status:
Implementation Priority: 4 Facility Function:
Implementation Phase: Implementation Date:
Official Responsible:
Notes:

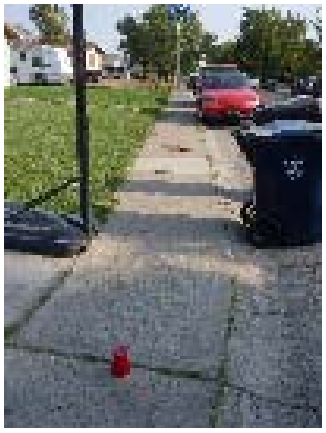
Field Date: 10/20/2010 Report Date: 10/20/2010 Barrier #: 1072B
Location: Gumwood Cir - South
X Coordinate: -121.30359
Y Coordinate: 38.70921
Barrier Area: Sidewalks
Barrier Type: Abrupt Change in Level - > 1/2"
Code Ref: CBC 1133B.7.1 and ADA/ABA 303.3
As Built Meas: 4 Quantity: LF
Description: Change in level greater than 1/2"
As Built Desc: 1" lip in sidewalk surface
Solution: Grind or repair sidewalk to remove trip hazard
Bar. Severity: 1 Necessary Cost Estimate: $1,000.00 Status:
Implementation Priority: 4 Facility Function:
Implementation Phase: Implementation Date:
Official Responsible:
Notes:

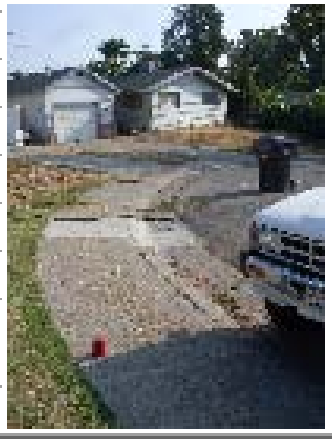
Field Date: 10/20/2010 Report Date: 10/20/2010 Barrier #: 1079A

Location: Sweetwood Ct - North
X Coordinate: -121.3038
Y Coordinate: 38.7114
Barrier Area: Sidewalks
Barrier Type: Cross Slope - Existing (5.0% or more)
Code Ref: CBC 1133B.7.1 and ADA/ABA 303.3
As Built Meas: 230 Quantity: LF
Description: Cross slope exceeds 2.0% (5.0% or more)
As Built Desc: 6.8% cross slope
Solution: Demolish existing and construct new route
Bar. Severity: 1 Necessary Cost Estimate: $28,750.00 Status:
Implementation Priority: 4 Facility Function:
Implementation Phase: Implementation Date:
Official Responsible:
Notes:

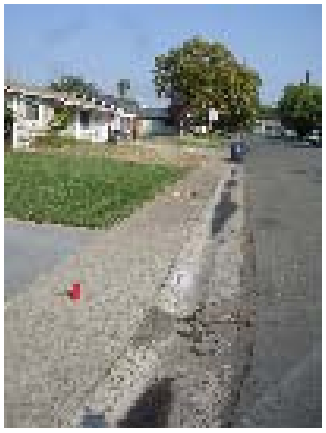
Field Date: 10/20/2010 Report Date: 10/20/2010 Barrier #: 1087
Location: Rollingwood Blvd and Rosswood Dr - Corner D
X Coordinate: -121.30046
Y Coordinate: 38.71196
Barrier Area: Curb Ramps
Barrier Type: Detectable Warnings - Truncated Domes (New Const)
Code Ref: CBC 1127B.5.3 and ADA/ABA 406.2
As Built Meas: 1 Quantity: EACH
Description: No truncated domes provided at curb ramp
As Built Desc: No detectable warnings at curb ramp - New Construction
Solution: Provide compliant truncated domes
Bar. Severity: 1 Necessary Cost Estimate: $1,400.00 Status:
Implementation Priority: 3 Facility Function:
Implementation Phase: Implementation Date:
Official Responsible:
Notes: Four - way intersection corners A,B,C,D

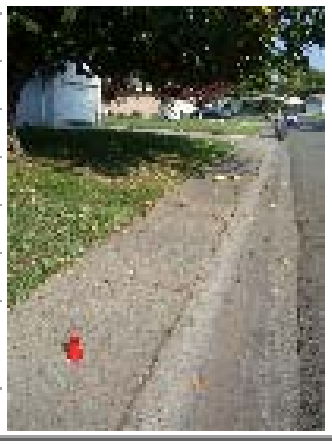
Field Date: 10/20/2010 Report Date: 10/20/2010 Barrier #: 1091

Location: Rosswood Dr - West

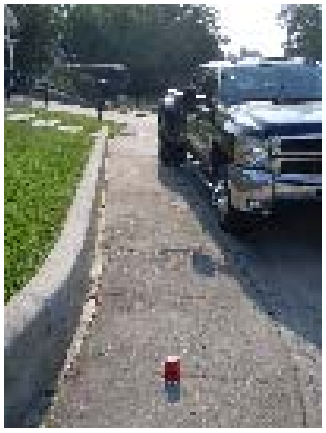
Field Date: 10/20/2010 Report Date: 10/20/2010 Barrier #: 1097

Location: Corkoaks Wy - North
X Coordinate: -121.30129
Y Coordinate: 38.71341
Barrier Area: Sidewalks
Barrier Type: Cross Slope - Existing (5.0% or more)
Code Ref: CBC 1133B.7.1 and ADA/ABA 303.3
As Built Meas: 477 Quantity: LF
Description: Cross slope exceeds 2.0% (5.0% or more)
As Built Desc: 8.3% cross slope
Solution: Demolish existing and construct new route
Bar. Severity: 1 Necessary Cost Estimate: $59,625.00 Status:
Implementation Priority: 4 Facility Function:
Implementation Phase: Implementation Date:
Official Responsible:
Notes:

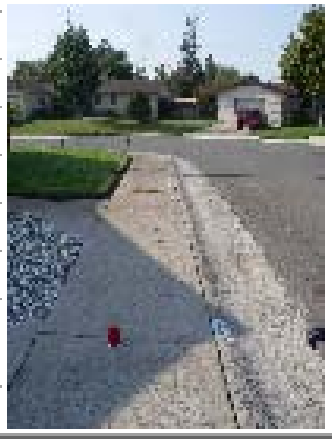
Field Date: 10/20/2010 Report Date: 10/20/2010 Barrier #: 1107

Location: Oakberry Wy - East
X Coordinate: -121.30262
Y Coordinate: 38.71247
Barrier Area: Sidewalks
Barrier Type: Cross Slope - Existing (5.0% or more)
Code Ref: CBC 1133B.7.1 and ADA/ABA 303.3
As Built Meas: 52 Quantity: LF
Description: Cross slope exceeds 2.0% (5.0% or more)
As Built Desc: 6.3% cross slope
Solution: Demolish existing and construct new route
Bar. Severity: 1 Necessary Cost Estimate: $6,500.00 Status:
Implementation Priority: 4 Facility Function:
Implementation Phase: Implementation Date:
Official Responsible:
Notes:

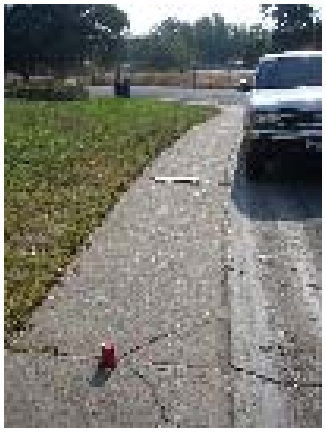
Field Date: 10/20/2010 Report Date: 10/20/2010 Barrier #: 1108

Location: Oakberry Wy - North
X Coordinate: -121.30289
Y Coordinate: 38.71207
Barrier Area: Sidewalks
Barrier Type: Cross Slope - Existing (4.1% to 4.9%)
Code Ref: CBC 1133B.7.1.3 and ADA/ABA 403.3
As Built Meas: 50 Quantity: LF
Description: Cross slope exceeds 2.0% (4.1% to 4.9%)
As Built Desc: 4.2% cross slope
Solution: Demolish existing and construct new route
Bar. Severity: 2 Recommended Cost Estimate: $6,250.00 Status:
Implementation Priority: 4 Facility Function:
Implementation Phase: Implementation Date:
Official Responsible:
Notes:

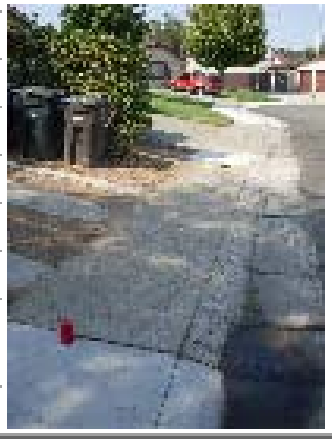
Location: Oakberry Wy - South
X Coordinate: -121.30265
Y Coordinate: 38.71179
Barrier Area: Sidewalks
Barrier Type: Cross Slope - Existing (4.1% to 4.9%)
Code Ref: CBC 1133B.7.1.3 and ADA/ABA 403.3
As Built Meas: 54 Quantity: LF
Description: Cross slope exceeds 2.0% (4.1% to 4.9%)
As Built Desc: 4.4% cross slope
Solution: Demolish existing and construct new route
Bar. Severity: 2 Recommended Cost Estimate: $6,750.00 Status:
Implementation Priority: 4 Facility Function:
Implementation Phase: Implementation Date:
Official Responsible:
Notes:

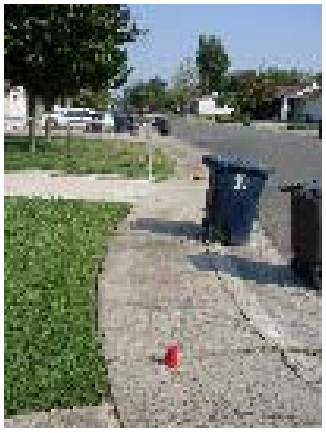
Field Date: 10/20/2010 Report Date: 10/20/2010 Barrier #: 1110

Location: Oakberry Wy - West
X Coordinate: -121.30299
Y Coordinate: 38.71228
Barrier Area: Sidewalks
Barrier Type: Cross Slope - Existing (5.0% or more)
Code Ref: CBC 1133B.7.1 and ADA/ABA 303.3
As Built Meas: 247 Quantity: LF
Description: Cross slope exceeds 2.0% (5.0% or more)
As Built Desc: 5.6% cross slope
Solution: Demolish existing and construct new route
Bar. Severity: 1 Necessary Cost Estimate: $30,875.00 Status:
Implementation Priority: 4 Facility Function:
Implementation Phase: Implementation Date:
Official Responsible:
Notes:

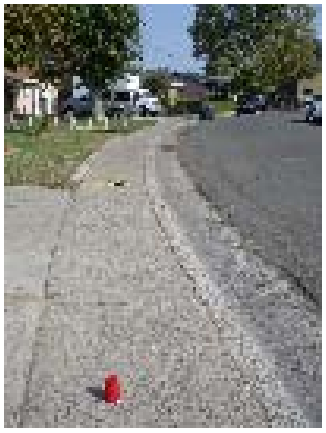
Field Date: 10/20/2010 Report Date: 10/20/2010 Barrier #: 1112

Location: Oakberry Wy - West
X Coordinate: -121.30093
Y Coordinate: 38.7142
Barrier Area: Sidewalks
Barrier Type: Cross Slope - Existing (5.0% or more)
Code Ref: CBC 1133B.7.1 and ADA/ABA 303.3
As Built Meas: 210 Quantity: LF
Description: Cross slope exceeds 2.0% (5.0% or more)
As Built Desc: 5.0% cross slope
Solution: Demolish existing and construct new route
Bar. Severity: 1 Necessary Cost Estimate: $26,250.00 Status:
Implementation Priority: 4 Facility Function:
Implementation Phase: Implementation Date:
Official Responsible:
Notes:

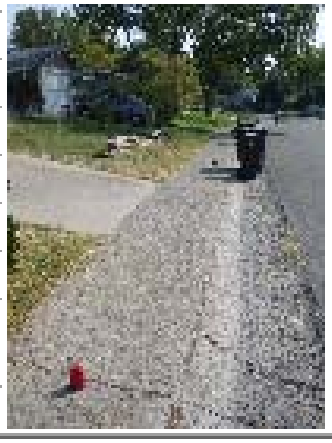
Field Date: 10/20/2010 Report Date: 10/20/2010 Barrier #: 1113

Location: Rosswood Dr - North
X Coordinate: -121.30077
Y Coordinate: 38.71394
Barrier Area: Sidewalks
Barrier Type: Cross Slope - Existing (5.0% or more)
Code Ref: CBC 1133B.7.1 and ADA/ABA 303.3
As Built Meas: 173 Quantity: LF
Description: Cross slope exceeds 2.0% (5.0% or more)
As Built Desc: 8.1% cross slope
Solution: Demolish existing and construct new route
Bar. Severity: 1 Necessary Cost Estimate: $21,625.00 Status:
Implementation Priority: 2 Facility Function:
Implementation Phase: Implementation Date:
Official Responsible:
Notes:

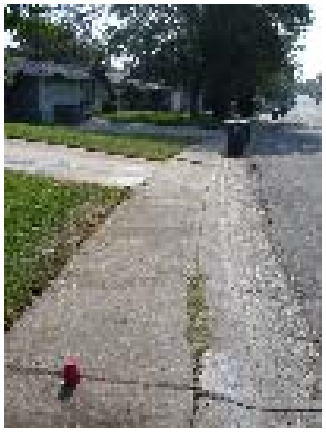
Field Date: 10/20/2010 Report Date: 10/20/2010 Barrier #: 1116A
Location: Rosswood Dr - East
X Coordinate: -121.30033
Y Coordinate: 38.71345
Barrier Area: Sidewalks
Barrier Type: Cross Slope - Existing (5.0% or more)
Code Ref: CBC 1133B.7.1 and ADA/ABA 303.3
As Built Meas: 480 Quantity: LF
Description: Cross slope exceeds 2.0% (5.0% or more)
As Built Desc: 5.3% cross slope
Solution: Demolish existing and construct new route
Bar. Severity: 1 Necessary Cost Estimate: $60,000.00 Status:
Implementation Priority: 2 Facility Function:
Implementation Phase: Implementation Date:
Official Responsible:
Notes:

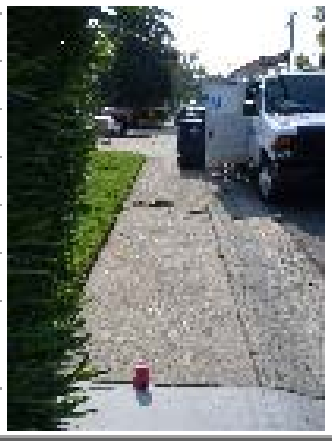
Location: Rosswood Dr - East
X Coordinate: -121.3003
Y Coordinate: 38.71179
Barrier Area: Sidewalks
Barrier Type: Cross Slope - Existing (4.1% to 4.9%)
Code Ref: CBC 1133B.7.1.3 and ADA/ABA 403.3
As Built Meas: 226 Quantity: LF
Description: Cross slope exceeds 2.0% (4.1% to 4.9%)
As Built Desc: 4.2% cross slope
Solution: Demolish existing and construct new route
Bar. Severity: 2 Recommended Cost Estimate: $28,250.00 Status:
Implementation Priority: 2 Facility Function:
Implementation Phase: Implementation Date:
Official Responsible:
Notes:

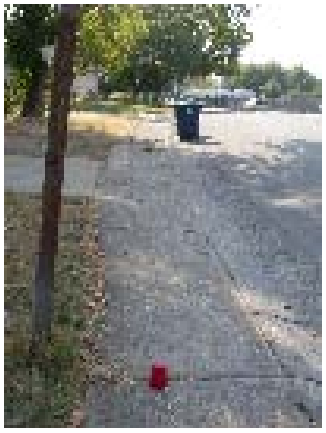
Field Date: 10/20/2010 Report Date: 10/20/2010 Barrier #: 1123A
Location: Rosswood Dr - East
X Coordinate: -121.30037
Y Coordinate: 38.71031
Barrier Area: Sidewalks
Barrier Type: Cross Slope - Existing (5.0% or more)
Code Ref: CBC 1133B.7.1 and ADA/ABA 303.3
As Built Meas: 578 Quantity: LF
Description: Cross slope exceeds 2.0% (5.0% or more)
As Built Desc: 5.7% cross slope
Solution: Demolish existing and construct new route
Bar. Severity: 1 Necessary Cost Estimate: $72,250.00 Status:
Implementation Priority: 2 Facility Function:
Implementation Phase: Implementation Date:
Official Responsible:
Notes:

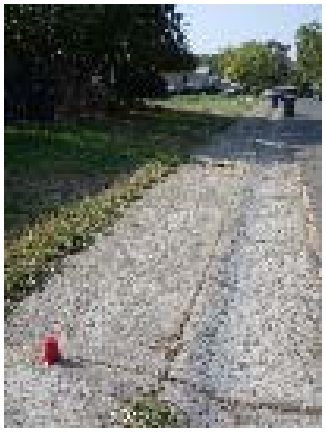
Field Date: 10/20/2010 Report Date: 10/20/2010 Barrier #: 1134A

Location: Parish Wy - South

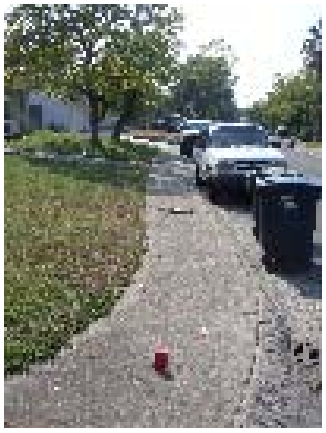
Field Date: 10/20/2010 Report Date: 10/20/2010 Barrier #: 1135A
Location: Parish Dr - East
X Coordinate: -121.30225
Y Coordinate: 38.70927
Barrier Area: Sidewalks
Barrier Type: Cross Slope - Existing (5.0% or more)
Code Ref: CBC 1133B.7.1 and ADA/ABA 303.3
As Built Meas: 482 Quantity: LF
Description: Cross slope exceeds 2.0% (5.0% or more)
As Built Desc: 9.6% cross slope
Solution: Demolish existing and construct new route
Bar. Severity: 1 Necessary Cost Estimate: $60,250.00 Status:
Implementation Priority: 4 Facility Function:
Implementation Phase: Implementation Date:
Official Responsible:
Notes:

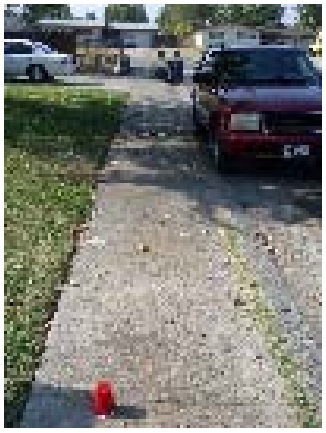
Field Date:	10/20/2010
Report Date:	10/20/2010
Barrier #:	1138
Location:	Parish Dr - South
X Coordinate:	-121.30331
Y Coordinate:	38.70797
Barrier Area:	Sidewalks
Barrier Type:	Cross Slope - Existing (5.0% or more)
Code Ref:	CBC 1133B.7.1 and ADA/ABA 303.3
As Built Meas:	129
Quantity:	LF
Description:	Cross slope exceeds 2.0% (5.0% or more)
As Built Desc:	6.4% cross slope
Solution:	Demolish existing and construct new route
Bar. Severity:	1 Necessary
Cost Estimate:	$16,125.00
Status:	
Implementation Priority:	4
Facility Function:	
Implementation Phase:	
Implementation Date:	
Official Responsible:	
Notes:

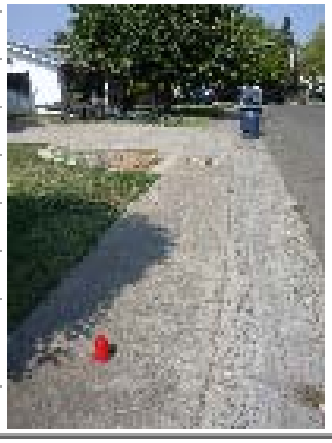
Location: Parish Wy - West
X Coordinate: -121.3025
Y Coordinate: 38.70921
Barrier Area: Sidewalks
Barrier Type: Cross Slope - Existing (5.0% or more)
Code Ref: CBC 1133B.7.1 and ADA/ABA 303.3
As Built Meas: 516 Quantity: LF
Description: Cross slope exceeds 2.0% (5.0% or more)
As Built Desc: 6.4% cross slope
Solution: Demolish existing and construct new route
Bar. Severity: 1 Necessary Cost Estimate: $64,500.00 Status:
Implementation Priority: 4 Facility Function:
Implementation Phase: Implementation Date:
Official Responsible:
Notes:

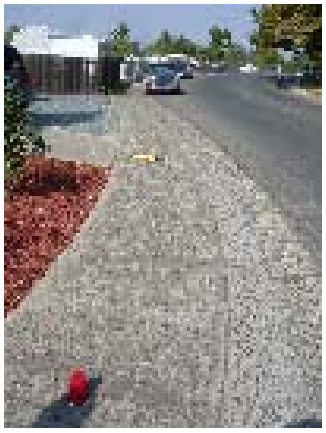
Field Date: 10/20/2010 Report Date: 10/20/2010 Barrier #: 1145
Location: Rosswood Dr - West
X Coordinate: -121.30048
Y Coordinate: 38.7095
Barrier Area: Sidewalks
Barrier Type: Cross Slope - Existing (4.1% to 4.9%)
Code Ref: CBC 1133B.7.1.3 and ADA/ABA 403.3
As Built Meas: 110 Quantity: LF
Description: Cross slope exceeds 2.0% (4.1% to 4.9%)
As Built Desc: 4.8% cross slope
Solution: Demolish existing and construct new route
Bar. Severity: 2 Recommended Cost Estimate: $13,750.00 Status:
Implementation Priority: 2 Facility Function:
Implementation Phase: Implementation Date:
Official Responsible:
Notes:

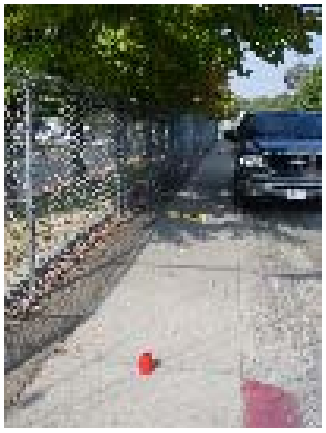
Field Date: 10/20/2010 Report Date: 10/20/2010 Barrier #: 1149A
Location: Rosswood Dr - West
X Coordinate: -121.30041
Y Coordinate: 38.71096
Barrier Area: Sidewalks
Barrier Type: Cross Slope - Existing (4.1% to 4.9%)
Code Ref: CBC 1133B.7.1.3 and ADA/ABA 403.3
As Built Meas: 210 Quantity: LF
Description: Cross slope exceeds 2.0% (4.1% to 4.9%)
As Built Desc: 4.7% cross slope
Solution: Demolish existing and construct new route
Bar. Severity: 2 Recommended Cost Estimate: $26,250.00 Status:
Implementation Priority: 2 Facility Function:
Implementation Phase: Implementation Date:
Official Responsible:
Notes:

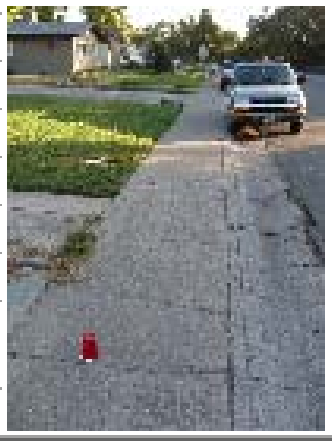
Field Date: 10/20/2010 Report Date: 10/20/2010 Barrier #: 1161
Location: Rollingwood Blvd - East
X Coordinate: -121.3036
Y Coordinate: 38.70868
Barrier Area: Sidewalks
Barrier Type: Clear Width - Existing (≤31” or less)
Code Ref: CBC 1133B.7.1
As Built Meas: 4 Quantity: LF
Description: Pedestrian route is not min. 48" wide (≤31” or less)
As Built Desc: 30" clear width due to pole
Solution: Demolish existing and construct new route
Bar. Severity: 1 Necessary Cost Estimate: $500.00 Status:
Implementation Priority: 3 Facility Function:
Implementation Phase: Implementation Date:
Official Responsible:
Notes:

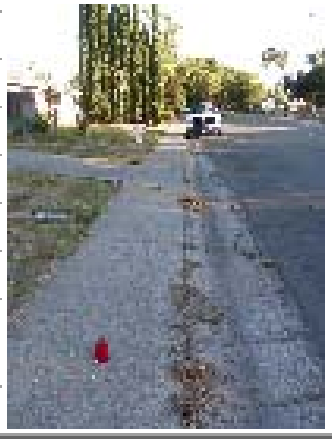
Field Date: 10/21/2010 Report Date: 10/21/2010 Barrier #: 1168

Location: Rollingwood Blvd - North
X Coordinate: -121.29872
Y Coordinate: 38.71282
Barrier Area: Sidewalks
Barrier Type: Cross Slope - Existing (5.0% or more)
Code Ref: CBC 1133B.7.1 and ADA/ABA 303.3
As Built Meas: 436 Quantity: LF
Description: Cross slope exceeds 2.0% (5.0% or more)
As Built Desc: 7.9% cross slope
Solution: Demolish existing and construct new route
Bar. Severity: 1 Necessary Cost Estimate: $54,500.00 Status:
Implementation Priority: 3 Facility Function:
Implementation Phase: Implementation Date:
Official Responsible:
Notes:

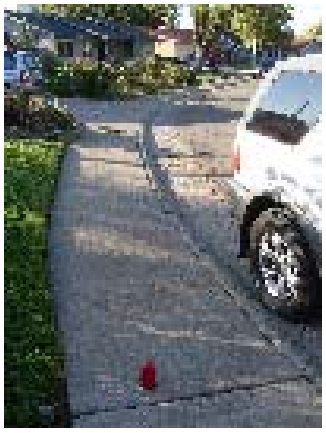
Field Date: 10/21/2010 Report Date: 10/21/2010 Barrier #: 1174
Location: Oakberry Wy and Little Oaks Wy - Corner D
X Coordinate: -121.29884
Y Coordinate: 38.71436
Barrier Area: Curb Ramps
Barrier Type: No Curb Ramp
Code Ref: CBC 1127B.5.3 and ADA/ABA 406.2
As Built Meas: 1 Quantity: EACH
Description: No curb cut at corner (intersection)
As Built Desc: No curb ramp at corner
Solution: Demolish existing and construct curb cut
Bar. Severity: 1 Necessary Cost Estimate: $2,500.00 Status:
Implementation Priority: 4 Facility Function:
Implementation Phase: Implementation Date:
Official Responsible:
Notes: Two - way intersection corners C,D

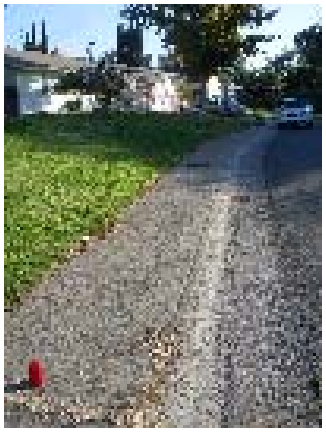
Field Date: 10/21/2010 Report Date: 10/21/2010 Barrier #: 1176B
Location: Little Oaks Wy - South
X Coordinate: -121.3003
Y Coordinate: 38.71359
Barrier Area: Sidewalks
Barrier Type: Abrupt Change in Level - > 1/2"
Code Ref: CBC 1133B.7.1 and ADA/ABA 303.3
As Built Meas: 4 Quantity: LF
Description: Change in level greater than 1/2"
As Built Desc: 1" lip in sidewalk surface
Solution: Grind or repair sidewalk to remove trip hazard
Bar. Severity: 1 Necessary Cost Estimate: $1,000.00 Status:
Implementation Priority: 4 Facility Function:
Implementation Phase: Implementation Date:
Official Responsible:
Notes:

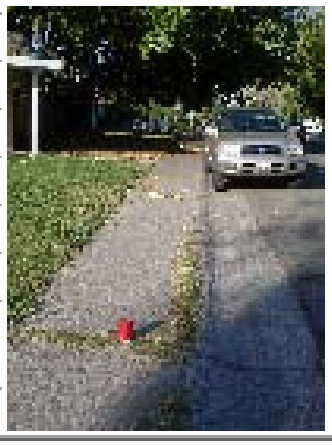
Field Date: 10/21/2010 Report Date: 10/21/2010 Barrier #: 1179B

Location: Oakberry Wy - South
X Coordinate: -121.29917
Y Coordinate: 38.71433
Barrier Area: Sidewalks
Barrier Type: Cross Slope - Existing (5.0% or more)
Code Ref: CBC 1133B.7.1 and ADA/ABA 303.3
As Built Meas: 578 Quantity: LF
Description: Cross slope exceeds 2.0% (5.0% or more)
As Built Desc: 6.1% cross slope
Solution: Demolish existing and construct new route
Bar. Severity: 1 Necessary Cost Estimate: $72,250.00 Status:
Implementation Priority: 4 Facility Function:
Implementation Phase: Implementation Date:
Official Responsible:
Notes:

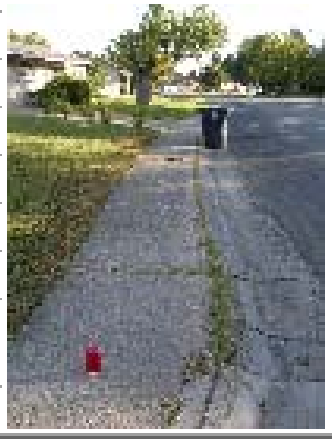
Location: Rollingwood Wy - North
X Coordinate: -121.29787
Y Coordinate: 38.71383
Barrier Area: Sidewalks
Barrier Type: Cross Slope - Existing (5.0% or more)
Code Ref: CBC 1133B.7.1 and ADA/ABA 303.3
As Built Meas: 207 Quantity: LF
Description: Cross slope exceeds 2.0% (5.0% or more)
As Built Desc: 5.9% cross slope
Solution: Demolish existing and construct new route
Bar. Severity: 1 Necessary Cost Estimate: $25,875.00 Status:
Implementation Priority: 3 Facility Function:
Implementation Phase: Implementation Date:
Official Responsible:
Notes:

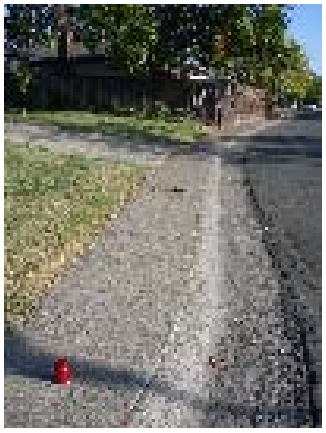
Field Date: 10/21/2010 Report Date: 10/21/2010 Barrier #: 1190
Location: Rousch Dr and Windfall Wy - Corner D
X Coordinate: -121.29751
Y Coordinate: 38.71489
Barrier Area: Curb Ramps
Barrier Type: No Curb Ramp
Code Ref: CBC 1127B.5.3 and ADA/ABA 406.2
As Built Meas: 1 Quantity: EACH
Description: No curb cut at corner (intersection)
As Built Desc: No curb ramp at corner
Solution: Demolish existing and construct curb cut
Bar. Severity: 1 Necessary Cost Estimate: $2,500.00 Status:
Implementation Priority: 4 Facility Function:
Implementation Phase: Implementation Date:
Official Responsible:
Notes: Two - way intersection corners A,D

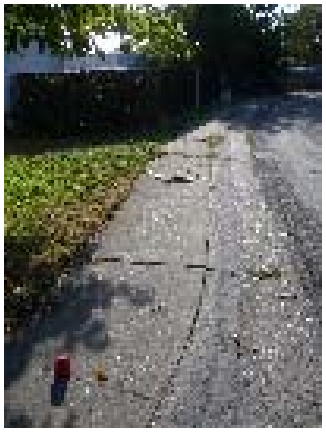
Field Date: 10/21/2010 Report Date: 10/21/2010 Barrier #: 1197B
Location: Woodruff Wy - East
X Coordinate: -121.29761
Y Coordinate: 38.71713
Barrier Area: Sidewalks
Barrier Type: Abrupt Change in Level - Tree Heaves
Code Ref: CBC 1133B.7.1 and ADA/ABA 303.3
As Built Meas: 4 Quantity: LF
Description: Change in level greater than 1/2"
As Built Desc: 1" lip due to tree heaves
Solution: Grind or repair sidewalk to remove trip hazard
Bar. Severity: 1 Necessary Cost Estimate: $1,000.00 Status:
Implementation Priority: 4 Facility Function:
Implementation Phase: Implementation Date:
Official Responsible:
Notes:

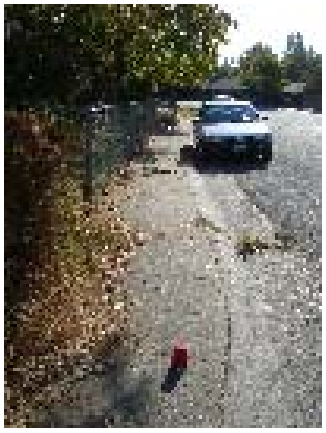
Field Date: 10/21/2010 Report Date: 10/21/2010 Barrier #: 1200
Location: Woodruff Wy and Black Oaks Wy - Corner B
X Coordinate: -121.29764
Y Coordinate: 38.71571
Barrier Area: Curb Ramps
Barrier Type: No Curb Ramp
Code Ref: CBC 1127B.5.3 and ADA/ABA 406.2
As Built Meas: 1 Quantity: EACH
Description: No curb cut at corner (intersection)
As Built Desc: No curb ramp at corner
Solution: Demolish existing and construct curb cut
Bar. Severity: 1 Necessary Cost Estimate: $2,500.00 Status:
Implementation Priority: 4 Facility Function:
Implementation Phase: Implementation Date:
Official Responsible:
Notes: Two - way intersection corners A,B

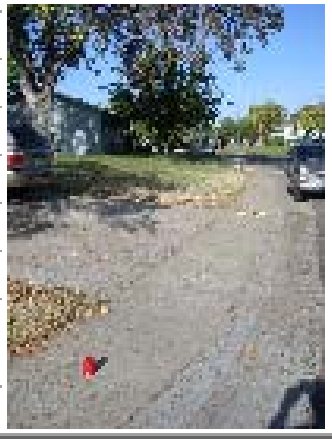
Field Date: 10/21/2010 Report Date: 10/21/2010 Barrier #: 1202A

Location: Black Oaks Wy - South
X Coordinate: -121.29727
Y Coordinate: 38.71547
Barrier Area: Sidewalks
Barrier Type: Cross Slope - Existing (5.0% or more)
Code Ref: CBC 1133B.7.1 and ADA/ABA 303.3
As Built Meas: 763 Quantity: LF
Description: Cross slope exceeds 2.0% (5.0% or more)
As Built Desc: 6.9% cross slope
Solution: Demolish existing and construct new route
Bar. Severity: 1 Necessary Cost Estimate: $95,375.00 Status:
Implementation Priority: 4 Facility Function:
Implementation Phase: Implementation Date:
Official Responsible:
Notes:

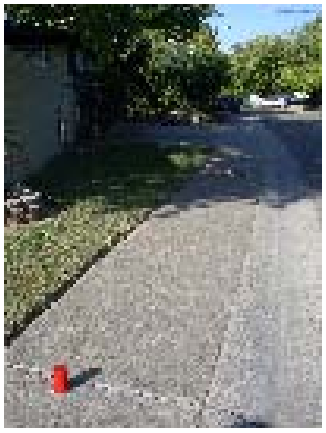
Field Date: 10/21/2010 Report Date: 10/21/2010 Barrier #: 1206A

Location: Windfall Wy - South
X Coordinate: -121.29797
Y Coordinate: 38.71504
Barrier Area: Sidewalks
Barrier Type: Cross Slope - Existing (5.0% or more)
Code Ref: CBC 1133B.7.1 and ADA/ABA 303.3
As Built Meas: 600 Quantity: LF
Description: Cross slope exceeds 2.0% (5.0% or more)
As Built Desc: 6.1% cross slope
Solution: Demolish existing and construct new route
Bar. Severity: 1 Necessary Cost Estimate: $75,000.00 Status:
Implementation Priority: 4 Facility Function:
Implementation Phase: Implementation Date:
Official Responsible:
Notes:

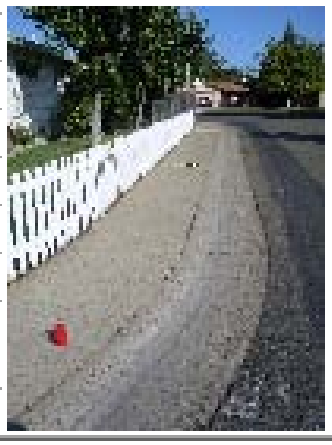
Field Date: 10/21/2010 Report Date: 10/21/2010 Barrier #: 1211

Location: Curlew Ct - West
X Coordinate: -121.29852
Y Coordinate: 38.71592
Barrier Area: Sidewalks
Barrier Type: Cross Slope - Existing (5.0% or more)
Code Ref: CBC 1133B.7.1 and ADA/ABA 303.3
As Built Meas: 220 Quantity: LF
Description: Cross slope exceeds 2.0% (5.0% or more)
As Built Desc: 5.3% cross slope
Solution: Demolish existing and construct new route
Bar. Severity: 1 Necessary Cost Estimate: $27,500.00 Status:
Implementation Priority: 4 Facility Function:
Implementation Phase: Implementation Date:
Official Responsible:
Notes:

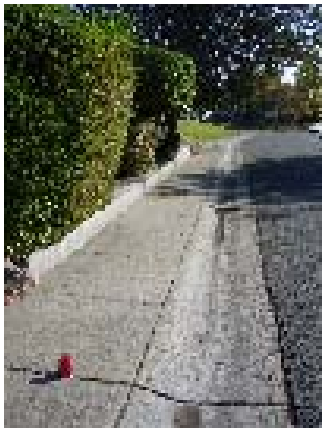
Field Date: 10/21/2010 Report Date: 10/21/2010 Barrier #: 1212B
Location: Curlew Ct - East
X Coordinate: -121.29846
Y Coordinate: 38.71613
Barrier Area: Sidewalks
Barrier Type: Abrupt Change in Level - > 1/2"
Code Ref: CBC 1133B.7.1 and ADA/ABA 303.3
As Built Meas: 4 Quantity: LF
Description: Change in level greater than 1/2"
As Built Desc: 1" lip in sidewalk surface
Solution: Grind or repair sidewalk to remove trip hazard
Bar. Severity: 1 Necessary Cost Estimate: $1,000.00 Status:
Implementation Priority: 4 Facility Function:
Implementation Phase: Implementation Date:
Official Responsible:
Notes:

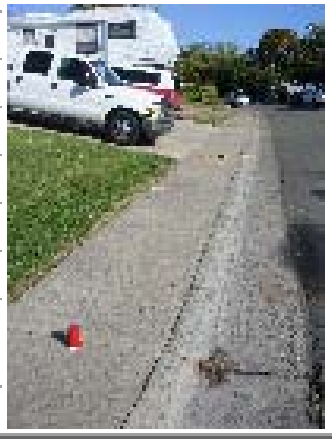
Location: Woodruff Wy - West
X Coordinate: -121.29779
Y Coordinate: 38.71575
Barrier Area: Sidewalks
Barrier Type: Cross Slope - Existing (5.0% or more)
Code Ref: CBC 1133B.7.1 and ADA/ABA 303.3
As Built Meas: 433 Quantity: LF
Description: Cross slope exceeds 2.0% (5.0% or more)
As Built Desc: 7.3% cross slope
Solution: Demolish existing and construct new route
Bar. Severity: 1 Necessary Cost Estimate: $54,125.00 Status:
Implementation Priority: 4 Facility Function:
Implementation Phase: Implementation Date:
Official Responsible:
Notes:

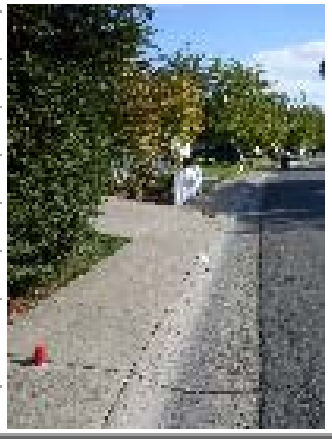
Field Date: 10/21/2010 Report Date: 10/21/2010 Barrier #: 1220A

Location: Woodruff Wy - North
X Coordinate: -121.29629
Y Coordinate: 38.71786
Barrier Area: Sidewalks
Barrier Type: Cross Slope - Existing (5.0% or more)
Code Ref: CBC 1133B.7.1 and ADA/ABA 303.3
As Built Meas: 677 Quantity: LF
Description: Cross slope exceeds 2.0% (5.0% or more)
As Built Desc: 5.5% cross slope
Solution: Demolish existing and construct new route
Bar. Severity: 1 Necessary Cost Estimate: $84,625.00 Status:
Implementation Priority: 4 Facility Function:
Implementation Phase: Implementation Date:
Official Responsible:
Notes:

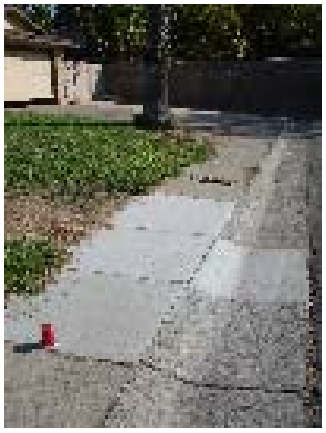
Field Date: 10/21/2010 Report Date: 10/21/2010 Barrier #: 1222B
Location: Woodruff Wy and Tallow Wood Wy - Corner D
X Coordinate: -121.29419
Y Coordinate: 38.71791
Barrier Area: Curb Ramps
Barrier Type: 12" Grooves - Existing (>5.0%)
Code Ref: CBC 1127B.5.6
As Built Meas: 1 Quantity: EACH
Description: 12" grooves at top of curb ramp are not level (>5.0%)
As Built Desc: 5.9% at 12" grooves
Solution: Demolish existing and construct new curb ramp
Bar. Severity: 1 Necessary Cost Estimate: $0.00 Status:
Implementation Priority: 4 Facility Function:
Implementation Phase: Implementation Date:
Official Responsible:
Notes: Three - way intersection corners B,C,D. Corners B,C and A-B compliant

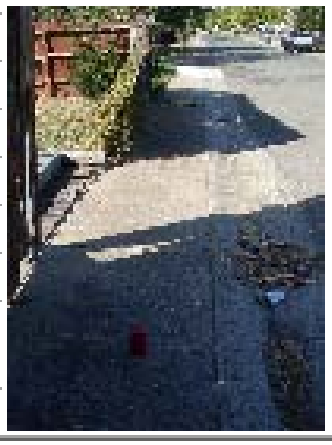
Field Date: 10/21/2010 Report Date: 10/21/2010 Barrier #: 1224

Location: Woodruff Wy - South
X Coordinate: -121.29397
Y Coordinate: 38.71796
Barrier Area: Sidewalks
Barrier Type: Cross Slope - Existing (5.0% or more)
Code Ref: CBC 1133B.7.1 and ADA/ABA 303.3
As Built Meas: 60 Quantity: LF
Description: Cross slope exceeds 2.0% (5.0% or more)
As Built Desc: 5.5% cross slope
Solution: Demolish existing and construct new route
Bar. Severity: 1 Necessary Cost Estimate: $7,500.00 Status:
Implementation Priority: 4 Facility Function:
Implementation Phase: Implementation Date:
Official Responsible:
Notes:

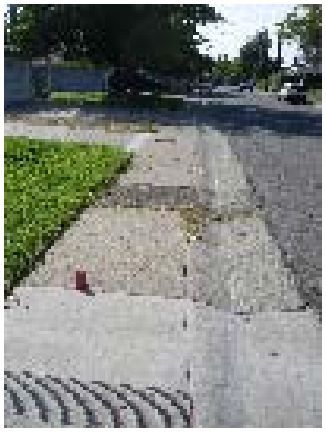
Field Date: 10/21/2010 Report Date: 10/21/2010 Barrier #: 1225A

Location: Tallow Wood Wy - East
X Coordinate: -121.2941
Y Coordinate: 38.7176
Barrier Area: Sidewalks
Barrier Type: Cross Slope - Existing (5.0% or more)
Code Ref: CBC 1133B.7.1 and ADA/ABA 303.3
As Built Meas: 438 Quantity: LF
Description: Cross slope exceeds 2.0% (5.0% or more)
As Built Desc: 5.6% cross slope
Solution: Demolish existing and construct new route
Bar. Severity: 1 Necessary Cost Estimate: $54,750.00 Status:
Implementation Priority: 4 Facility Function:
Implementation Phase: Implementation Date:
Official Responsible:
Notes:

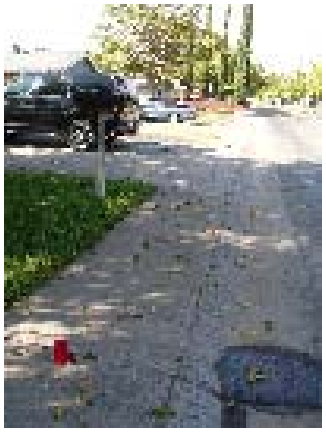
Field Date: 10/21/2010 Report Date: 10/21/2010 Barrier #: 1230

Location: Woodruff Wy - South
X Coordinate: -121.2943
Y Coordinate: 38.71794
Barrier Area: Sidewalks
Barrier Type: Cross Slope - Existing (5.0% or more)
Code Ref: CBC 1133B.7.1 and ADA/ABA 303.3
As Built Meas: 855 Quantity: LF
Description: Cross slope exceeds 2.0% (5.0% or more)
As Built Desc: 7.0% cross slope
Solution: Demolish existing and construct new route
Bar. Severity: 1 Necessary Cost Estimate: $106,875.00 Status:
Implementation Priority: 4 Facility Function:
Implementation Phase: Implementation Date:
Official Responsible:
Notes:

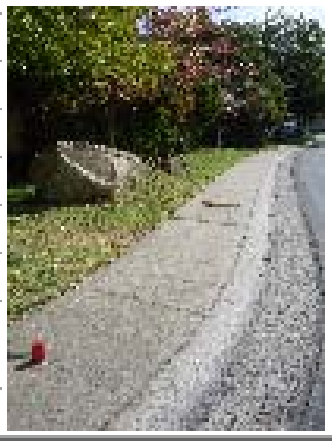
Field Date: 10/21/2010 Report Date: 10/21/2010 Barrier #: 1231

Location: Rousch Dr - East
X Coordinate: -121.29719
Y Coordinate: 38.71733
Barrier Area: Sidewalks
Barrier Type: Cross Slope - Existing (5.0% or more)
Code Ref: CBC 1133B.7.1 and ADA/ABA 303.3
As Built Meas: 191 Quantity: LF
Description: Cross slope exceeds 2.0% (5.0% or more)
As Built Desc: 5.2% cross slope
Solution: Demolish existing and construct new route
Bar. Severity: 1 Necessary Cost Estimate: $23,875.00 Status:
Implementation Priority: 4 Facility Function:
Implementation Phase: Implementation Date:
Official Responsible:
Notes:

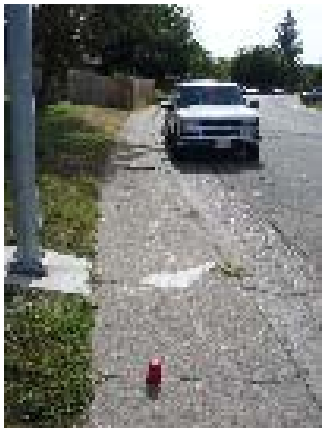
Field Date: 10/21/2010 Report Date: 10/21/2010 Barrier #: 1236A

Location: Rousch Dr - East
X Coordinate: -121.29671
Y Coordinate: 38.71674
Barrier Area: Sidewalks
Barrier Type: Cross Slope - Existing (5.0% or more)
Code Ref: CBC 1133B.7.1 and ADA/ABA 303.3
As Built Meas: 169 Quantity: LF
Description: Cross slope exceeds 2.0% (5.0% or more)
As Built Desc: 6.1% cross slope
Solution: Demolish existing and construct new route
Bar. Severity: 1 Necessary Cost Estimate: $21,125.00 Status:
Implementation Priority: 4 Facility Function:
Implementation Phase: Implementation Date:
Official Responsible:
Notes:

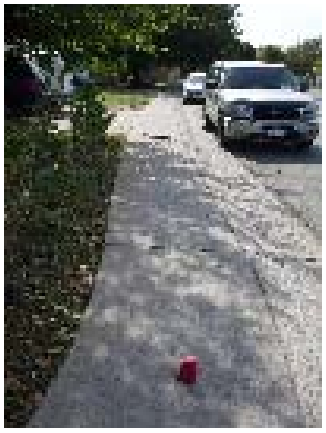
Field Date: 10/21/2010 Report Date: 10/21/2010 Barrier #: 1238
Location: Rousch Dr and Sandelwood Dr - Corner C
X Coordinate: -121.29662
Y Coordinate: 38.71614
Barrier Area: Curb Ramps
Barrier Type: No Curb Ramp
Code Ref: CBC 1127B.5.3 and ADA/ABA 406.2
As Built Meas: 1 Quantity: EACH
Description: No curb cut at corner (intersection)
As Built Desc: No curb ramp at corner
Solution: Demolish existing and construct curb cut
Bar. Severity: 1 Necessary Cost Estimate: $2,500.00 Status:
Implementation Priority: 4 Facility Function:
Implementation Phase: Implementation Date:
Official Responsible:
Notes: Two - way intersection corners B,C

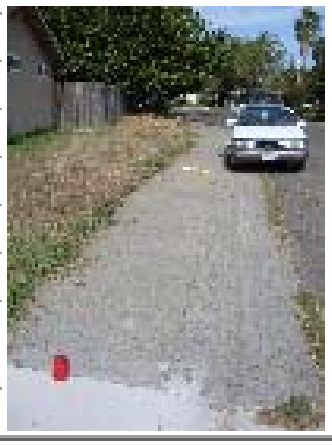
Location: Baymore Wy - West
X Coordinate: -121.2948
Y Coordinate: 38.71593
Barrier Area: Sidewalks
Barrier Type: Cross Slope - Existing (4.1% to 4.9%)
Code Ref: CBC 1133B.7.1.3 and ADA/ABA 403.3
As Built Meas: 186 Quantity: LF
Description: Cross slope exceeds 2.0% (4.1% to 4.9%)
As Built Desc: 4.3% cross slope
Solution: Demolish existing and construct new route
Bar. Severity: 2 Recommended Cost Estimate: $23,250.00 Status:
Implementation Priority: 4 Facility Function:
Implementation Phase: Implementation Date:
Official Responsible:
Notes:

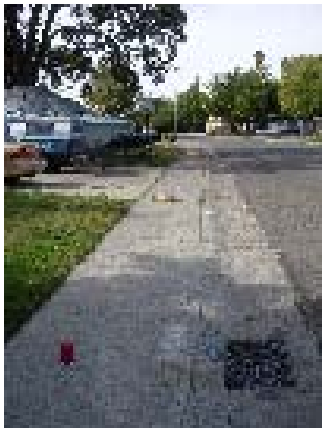
Field Date: 10/21/2010 Report Date: 10/21/2010 Barrier #: 1244
Location: Baymore Wy and Sandalwood Dr - Corner D
X Coordinate: -121.2948
Y Coordinate: 38.71651
Barrier Area: Curb Ramps
Barrier Type: No Curb Ramp - Depressed Exsiting Curb
Code Ref: CBC 1127B.5.3 and ADA/ABA 406.2
As Built Meas: 1 Quantity: EACH
Description: No compliant curb cut at corner (intersection)
As Built Desc: 9.0% running slope at depressed area
Solution: Demolish existing and construct curb cut
Bar. Severity: 1 Necessary Cost Estimate: $2,500.00 Status:
Implementation Priority: 4 Facility Function:
Implementation Phase: Implementation Date:
Official Responsible:
Notes: Two - way intersection corners C,D

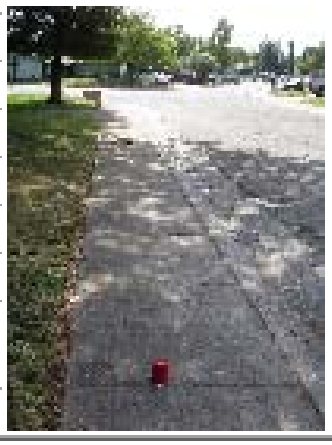
Field Date: 10/21/2010 Report Date: 10/21/2010 Barrier #: 1251

Location: Shady Crest Wy - East
X Coordinate: -121.29324
Y Coordinate: 38.71704
Barrier Area: Sidewalks
Barrier Type: Cross Slope - Existing (5.0% or more)
Code Ref: CBC 1133B.7.1 and ADA/ABA 303.3
As Built Meas: 78 Quantity: LF
Description: Cross slope exceeds 2.0% (5.0% or more)
As Built Desc: 6.4% cross slope
Solution: Demolish existing and construct new route
Bar. Severity: 1 Necessary Cost Estimate: $9,750.00 Status:
Implementation Priority: 4 Facility Function:
Implementation Phase: Implementation Date:
Official Responsible:
Notes:

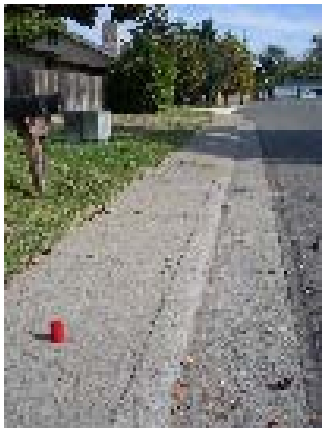
Field Date: 10/21/2010 Report Date: 10/21/2010 Barrier #: 1256
Location: Sandalwood Dr - North
X Coordinate: -121.2916
Y Coordinate: 38.71605
Barrier Area: Sidewalks
Barrier Type: Running Slope (Existing)
Code Ref: CBC 1133B.8.5
As Built Meas: 22 Quantity: LF
Description: Running slope exceeds 5.0%
As Built Desc: 7.4% running slope
Solution: No remediation where sidewalk sloped as roadway
Bar. Severity: 5 Technically Infeasible Cost Estimate: $0.00 Status:
Implementation Priority: 4 Facility Function:
Implementation Phase: Implementation Date:
Official Responsible:
Notes:

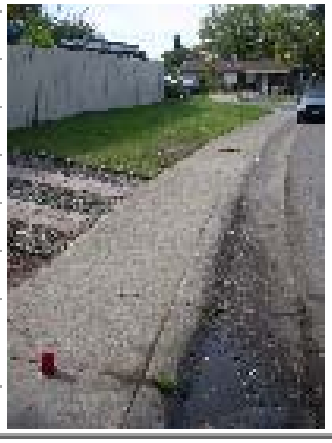
Field Date: 10/21/2010 Report Date: 10/21/2010 Barrier #: 1272

Location: Sandalwood Dr - South
X Coordinate: -121.29269
Y Coordinate: 38.71594
Barrier Area: Sidewalks
Barrier Type: Cross Slope - Existing (5.0% or more)
Code Ref: CBC 1133B.7.1 and ADA/ABA 303.3
As Built Meas: 85 Quantity: LF
Description: Cross slope exceeds 2.0% (5.0% or more)
As Built Desc: 5.0% cross slope
Solution: Demolish existing and construct new route
Bar. Severity: 1 Necessary Cost Estimate: $10,625.00 Status:
Implementation Priority: 4 Facility Function:
Implementation Phase: Implementation Date:
Official Responsible:
Notes:

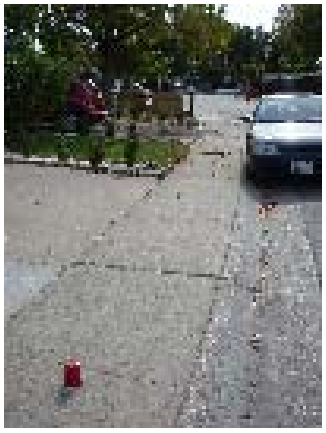
Field Date: 10/21/2010 Report Date: 10/21/2010 Barrier #: 1275A
Location: Cordelia Cr - East
X Coordinate: -121.29288
Y Coordinate: 38.71569
Barrier Area: Sidewalks
Barrier Type: Cross Slope - Existing (5.0% or more)
Code Ref: CBC 1133B.7.1 and ADA/ABA 303.3
As Built Meas: 308 Quantity: LF
Description: Cross slope exceeds 2.0% (5.0% or more)
As Built Desc: 5.2% cross slope
Solution: Demolish existing and construct new route
Bar. Severity: 1 Necessary Cost Estimate: $38,500.00 Status:
Implementation Priority: 4 Facility Function:
Implementation Phase: Implementation Date:
Official Responsible:
Notes:

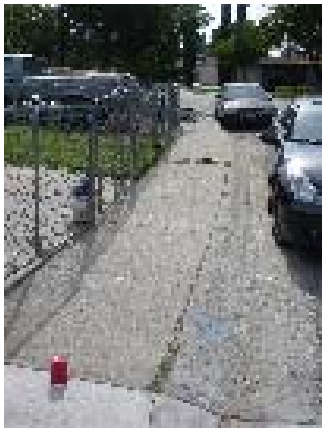
Field Date: 10/21/2010 Report Date: 10/21/2010 Barrier #: 1278A

Location: Cordelia Cr - East
X Coordinate: -121.29375
Y Coordinate: 38.716
Barrier Area: Sidewalks
Barrier Type: Cross Slope - Existing (5.0% or more)
Code Ref: CBC 1133B.7.1 and ADA/ABA 303.3
As Built Meas: 367 Quantity: LF
Description: Cross slope exceeds 2.0% (5.0% or more)
As Built Desc: 5.2% cross slope
Solution: Demolish existing and construct new route
Bar. Severity: 1 Necessary Cost Estimate: $45,875.00 Status:
Implementation Priority: 4 Facility Function:
Implementation Phase: Implementation Date:
Official Responsible:
Notes:

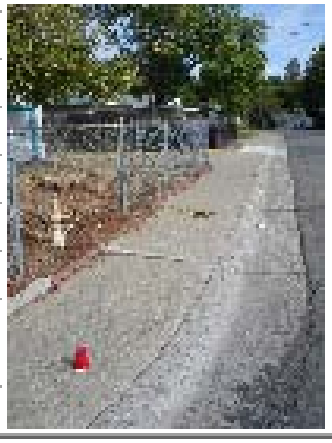
Location: Cordelia Cr - North
X Coordinate: -121.29371
Y Coordinate: 38.71514
Barrier Area: Sidewalks
Barrier Type: Cross Slope - Existing (5.0% or more)
Code Ref: CBC 1133B.7.1 and ADA/ABA 303.3
As Built Meas: 184 Quantity: LF
Description: Cross slope exceeds 2.0% (5.0% or more)
As Built Desc: 8.9% cross slope
Solution: Demolish existing and construct new route
Bar. Severity: 1 Necessary Cost Estimate: $23,000.00 Status:
Implementation Priority: 4 Facility Function:
Implementation Phase: Implementation Date:
Official Responsible:
Notes:

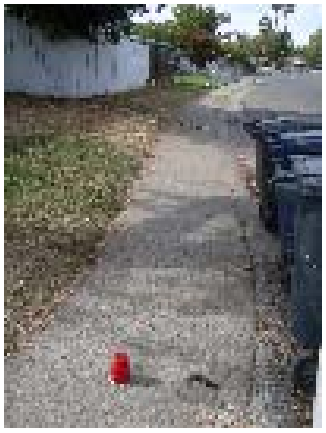
Field Date: 10/21/2010 Report Date: 10/21/2010 Barrier #: 1281

Location: Sandalwood Dr - South
X Coordinate: -121.29308
Y Coordinate: 38.71602
Barrier Area: Sidewalks
Barrier Type: Cross Slope - Existing (5.0% or more)
Code Ref: CBC 1133B.7.1 and ADA/ABA 303.3
As Built Meas: 173 Quantity: LF
Description: Cross slope exceeds 2.0% (5.0% or more)
As Built Desc: 5.1% cross slope
Solution: Demolish existing and construct new route
Bar. Severity: 1 Necessary Cost Estimate: $21,625.00 Status:
Implementation Priority: 4 Facility Function:
Implementation Phase: Implementation Date:
Official Responsible:
Notes:

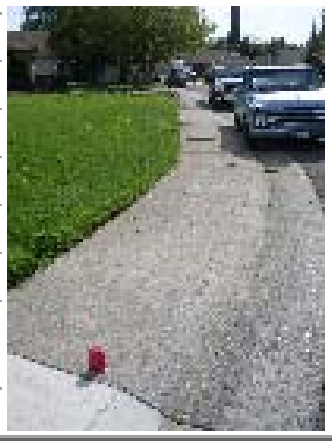
Field Date: 10/21/2010 Report Date: 10/21/2010 Barrier #: 1284

Location: Bayoak Wy - East
X Coordinate: -121.29573
Y Coordinate: 38.71552
Barrier Area: Sidewalks
Barrier Type: Cross Slope - Existing (5.0% or more)
Code Ref: CBC 1133B.7.1 and ADA/ABA 303.3
As Built Meas: 200 Quantity: LF
Description: Cross slope exceeds 2.0% (5.0% or more)
As Built Desc: 5.3% cross slope
Solution: Demolish existing and construct new route
Bar. Severity: 1 Necessary Cost Estimate: $25,000.00 Status:
Implementation Priority: 4 Facility Function:
Implementation Phase: Implementation Date:
Official Responsible:
Notes:

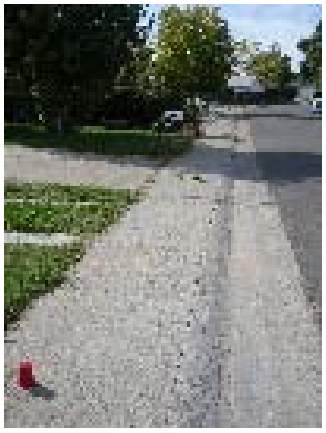
Field Date: 10/21/2010 Report Date: 10/21/2010 Barrier #: 1285

Location: Bayoak Wy - South
X Coordinate: -121.29616
Y Coordinate: 38.71502
Barrier Area: Sidewalks
Barrier Type: Cross Slope - Existing (4.1% to 4.9%)
Code Ref: CBC 1133B.7.1.3 and ADA/ABA 403.3
As Built Meas: 310 Quantity: LF
Description: Cross slope exceeds 2.0% (4.1% to 4.9%)
As Built Desc: 4.6% cross slope
Solution: Demolish existing and construct new route
Bar. Severity: 2 Recommended Cost Estimate: $38,750.00 Status:
Implementation Priority: 4 Facility Function:
Implementation Phase: Implementation Date:
Official Responsible:
Notes:

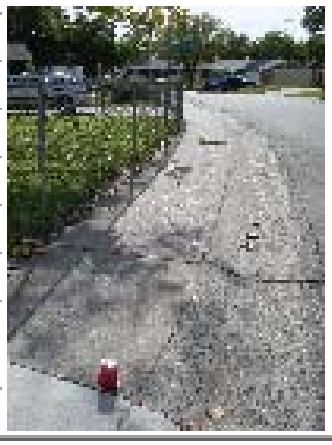
Location: Rousch Dr - East
X Coordinate: -121.29724
Y Coordinate: 38.71507
Barrier Area: Sidewalks
Barrier Type: Cross Slope - Existing (5.0% or more)
Code Ref: CBC 1133B.7.1 and ADA/ABA 303.3
As Built Meas: 357 Quantity: LF
Description: Cross slope exceeds 2.0% (5.0% or more)
As Built Desc: 5.2% cross slope
Solution: Demolish existing and construct new route
Bar. Severity: 1 Necessary Cost Estimate: $44,625.00 Status:
Implementation Priority: 4 Facility Function:
Implementation Phase: Implementation Date:
Official Responsible:
Notes:

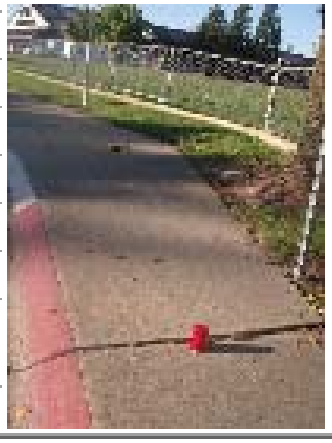
Field Date: 10/27/2010 Report Date: 10/27/2010 Barrier #: 1683A

Location: Carriage Dr - West
X Coordinate: -121.29506
Y Coordinate: 38.70335
Barrier Area: Sidewalks
Barrier Type: Cross Slope - Existing (5.0% or more)
Code Ref: CBC 1133B.7.1 and ADA/ABA 303.3
As Built Meas: 45 Quantity: LF
Description: Cross slope exceeds 2.0% (5.0% or more)
As Built Desc: 5.8% cross slope
Solution: Demolish existing and construct new route
Bar. Severity: 1 Necessary Cost Estimate: $5,625.00 Status:
Implementation Priority: 3 Facility Function:
Implementation Phase: Implementation Date:
Official Responsible:
Notes:

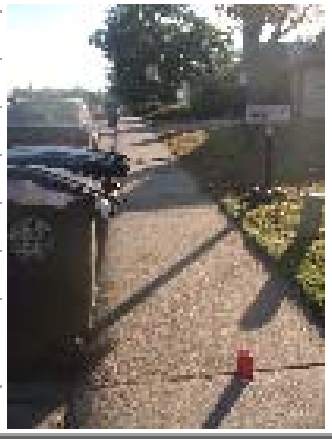
Location: Pratt Ave - South
X Coordinate: -121.29465
Y Coordinate: 38.70314
Barrier Area: Sidewalks
Barrier Type: Cross Slope - Existing (5.0% or more)
Code Ref: CBC 1133B.7.1 and ADA/ABA 303.3
As Built Meas: 521 Quantity: LF
Description: Cross slope exceeds 2.0% (5.0% or more)
As Built Desc: 5.2% cross slope
Solution: Demolish existing and construct new route
Bar. Severity: 1 Necessary Cost Estimate: $65,125.00 Status:
Implementation Priority: 4 Facility Function:
Implementation Phase: Implementation Date:
Official Responsible:
Notes:

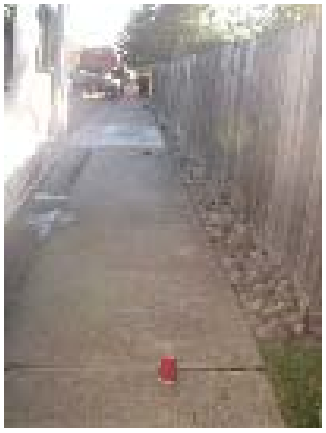
Field Date: 10/27/2010 Report Date: 10/27/2010 Barrier #: 1687
Location: Pratt Ave - South
X Coordinate: -121.29249
Y Coordinate: 38.70317
Barrier Area: Sidewalks
Barrier Type: Cross Slope - Existing (5.0% or more)
Code Ref: CBC 1133B.7.1 and ADA/ABA 303.3
As Built Meas: 140 Quantity: LF
Description: Cross slope exceeds 2.0% (5.0% or more)
As Built Desc: 5.3% cross slope
Solution: Demolish existing and construct new route
Bar. Severity: 1 Necessary Cost Estimate: $17,500.00 Status:
Implementation Priority: 4 Facility Function:
Implementation Phase: Implementation Date:
Official Responsible:
Notes:

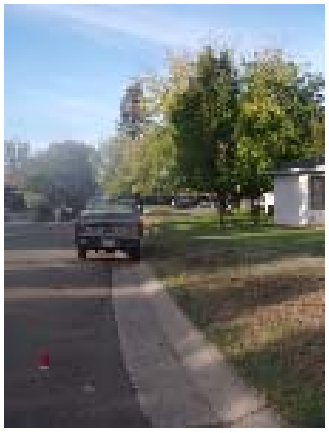
Field Date: 11/3/2010 Report Date: 11/3/2010 Barrier #: 1942
Location: Brill Ct - West
X Coordinate: -121.30654
Y Coordinate: 38.69904
Barrier Area: Sidewalks
Barrier Type: No sidewalk
Code Ref: CBC 1133B.7.1.3 and ADA/ABA 403.3
As Built Meas: 380 Quantity: LF
Description: No pedestrian route provided
As Built Desc: No sidewalk provided
Solution: Construct new firm and stable pedestrian route
Bar. Severity: 1 Necessary Cost Estimate: $38,000.00 Status:
Implementation Priority: 4 Facility Function:
Implementation Phase: Implementation Date:
Official Responsible:
Notes:

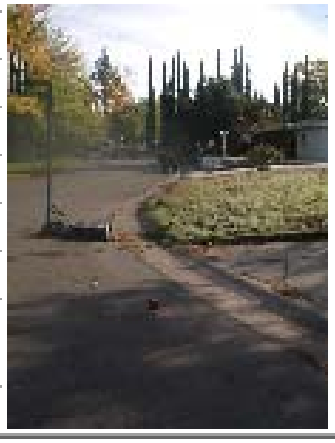
Field Date: 11/3/2010 Report Date: 11/3/2010 Barrier #: 1943

Location: Brill Ct - East
X Coordinate: -121.30751
Y Coordinate: 38.69874
Barrier Area: Sidewalks
Barrier Type: No sidewalk
Code Ref: CBC 1133B.7.1.3 and ADA/ABA 403.3
As Built Meas: 390 Quantity: LF
Description: No pedestrian route provided
As Built Desc: No sidewalk provided
Solution: Construct new firm and stable pedestrian route
Bar. Severity: 1 Necessary Cost Estimate: $39,000.00 Status:
Implementation Priority: 4 Facility Function:
Implementation Phase: Implementation Date:
Official Responsible:
Notes:

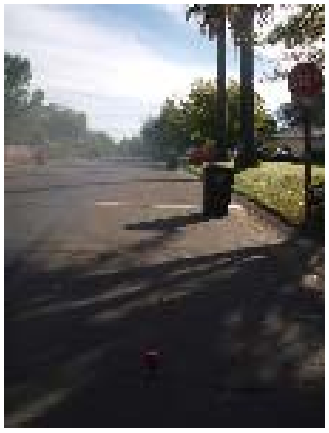
Field Date: 11/3/2010 Report Date: 11/3/2010 Barrier #: 1944

Location: Calvin Dr - South
X Coordinate: -121.30617
Y Coordinate: 38.6989
Barrier Area: Sidewalks
Barrier Type: No sidewalk
Code Ref: CBC 1133B.7.1.3 and ADA/ABA 403.3
As Built Meas: 870 Quantity: LF
Description: No pedestrian route provided
As Built Desc: No sidewalk provided
Solution: Construct new firm and stable pedestrian route
Bar. Severity: 1 Necessary Cost Estimate: $87,000.00 Status:
Implementation Priority: 4 Facility Function:
Implementation Phase: Implementation Date:
Official Responsible:
Notes:
