CITY OF CITRUS HEIGHTS

DRAFT ADA TRANSITION PLAN UPDATE

NEIGHBORHOOD AREA 2 RUSCH PARK

SEPTEMBER 20, 2011

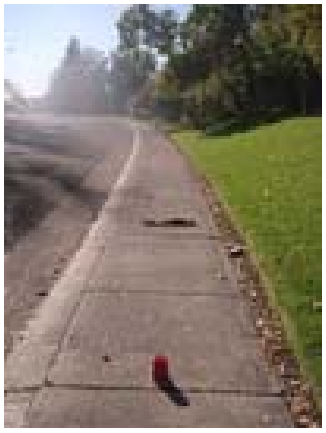
Field Date: 11/9/2010 Report Date: 11/9/2010 Barrier #: 2120
Location: Raintree Dr - West
X Coordinate: -121.29776
Y Coordinate: 38.69442
Barrier Area: Sidewalks
Barrier Type: Cross Slope - Existing (5.0% or more)
Code Ref: CBC 1133B.7.1 and ADA/ABA 303.3
As Built Meas: 190 Quantity: LF
Description: Cross slope exceeds 2.0% (5.0% or more)
As Built Desc: 6.1% cross slope
Solution: Demolish existing and construct new route
Bar. Severity: 1 Necessary Cost Estimate: $23,750.00 Status:
Implementation Priority: 4 Facility Function:
Implementation Phase: Implementation Date:
Official Responsible:
Notes:

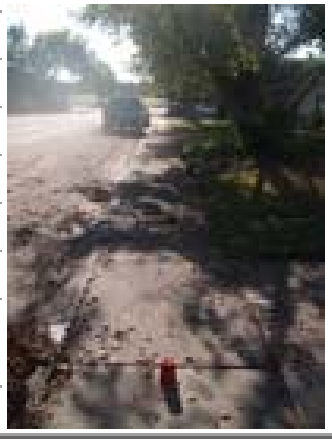
Location: Raintree Dr - West
X Coordinate: -121.29739
Y Coordinate: 38.69339
Barrier Area: Sidewalks
Barrier Type: Cross Slope - Existing (5.0% or more)
Code Ref: CBC 1133B.7.1 and ADA/ABA 303.3
As Built Meas: 248 Quantity: LF
Description: Cross slope exceeds 2.0% (5.0% or more)
As Built Desc: 5.5% cross slope
Solution: Demolish existing and construct new route
Bar. Severity: 1 Necessary Cost Estimate: $31,000.00 Status:
Implementation Priority: 4 Facility Function:
Implementation Phase: Implementation Date:
Official Responsible:
Notes:

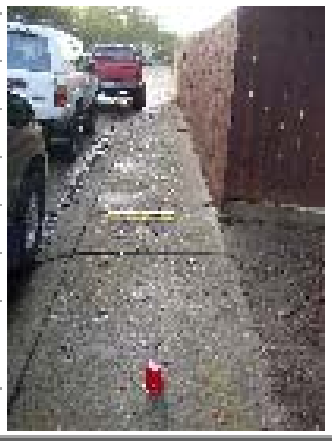
Field Date: 10/25/2010 Report Date: 10/25/2010 Barrier #: 1408

Location: Rusch Dr - South
X Coordinate: -121.29708
Y Coordinate: 38.71392
Barrier Area: Sidewalks
Barrier Type: Cross Slope - Existing (5.0% or more)
Code Ref: CBC 1133B.7.1 and ADA/ABA 303.3
As Built Meas: 109 Quantity: LF
Description: Cross slope exceeds 2.0% (5.0% or more)
As Built Desc: 5.1% cross slope
Solution: Demolish existing and construct new route
Bar. Severity: 1 Necessary Cost Estimate: $13,625.00 Status:
Implementation Priority: 4 Facility Function:
Implementation Phase: Implementation Date:
Official Responsible:
Notes:

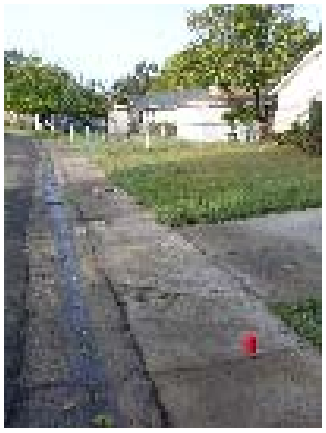
Field Date: 10/25/2010 Report Date: 10/25/2010 Barrier #: 1411

Location: Lesser Dr - West
X Coordinate: -121.29705
Y Coordinate: 38.7135
Barrier Area: Sidewalks
Barrier Type: Cross Slope - Existing (5.0% or more)
Code Ref: CBC 1133B.7.1 and ADA/ABA 303.3
As Built Meas: 1325 Quantity: LF
Description: Cross slope exceeds 2.0% (5.0% or more)
As Built Desc: 8.2% cross slope
Solution: Demolish existing and construct new route
Bar. Severity: 1 Necessary Cost Estimate: $165,625.00 Status:
Implementation Priority: 4 Facility Function:
Implementation Phase: Implementation Date:
Official Responsible:
Notes:

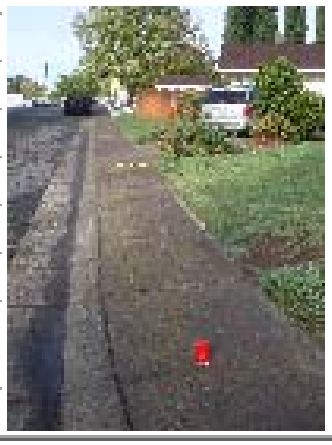
Field Date: 10/25/2010 Report Date: 10/25/2010 Barrier #: 1414

Location: Grand Oaks Blvd - North
X Coordinate: -121.29957
Y Coordinate: 38.71064
Barrier Area: Sidewalks
Barrier Type: Cross Slope - Existing (5.0% or more)
Code Ref: CBC 1133B.7.1 and ADA/ABA 303.3
As Built Meas: 216 Quantity: LF
Description: Cross slope exceeds 2.0% (5.0% or more)
As Built Desc: 5.8% cross slope
Solution: Demolish existing and construct new route
Bar. Severity: 1 Necessary Cost Estimate: $27,000.00 Status:
Implementation Priority: 4 Facility Function:
Implementation Phase: Implementation Date:
Official Responsible:
Notes:

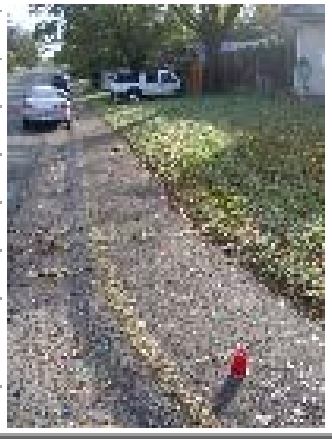
Field Date: 10/25/2010 Report Date: 10/25/2010 Barrier #: 1415

Location: Grand Oaks Blvd - South
X Coordinate: -121.30021
Y Coordinate: 38.71051
Barrier Area: Sidewalks
Barrier Type: Cross Slope - Existing (5.0% or more)
Code Ref: CBC 1133B.7.1 and ADA/ABA 303.3
As Built Meas: 1090 Quantity: LF
Description: Cross slope exceeds 2.0% (5.0% or more)
As Built Desc: 12.3% cross slope
Solution: Demolish existing and construct new route
Bar. Severity: 1 Necessary Cost Estimate: $136,250.00 Status:
Implementation Priority: 4 Facility Function:
Implementation Phase: Implementation Date:
Official Responsible:
Notes:

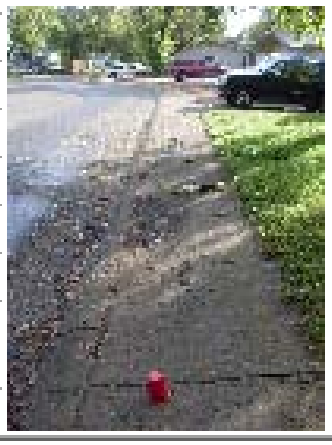
Field Date: 10/25/2010 Report Date: 10/25/2010 Barrier #: 1423

Location: Rusch Dr - South
X Coordinate: -121.29707
Y Coordinate: 38.70973
Barrier Area: Sidewalks
Barrier Type: Cross Slope - Existing (5.0% or more)
Code Ref: CBC 1133B.7.1 and ADA/ABA 303.3
As Built Meas: 179 Quantity: LF
Description: Cross slope exceeds 2.0% (5.0% or more)
As Built Desc: 10.2% cross slope
Solution: Demolish existing and construct new route
Bar. Severity: 1 Necessary Cost Estimate: $22,375.00 Status:
Implementation Priority: 4 Facility Function:
Implementation Phase: Implementation Date:
Official Responsible:
Notes:

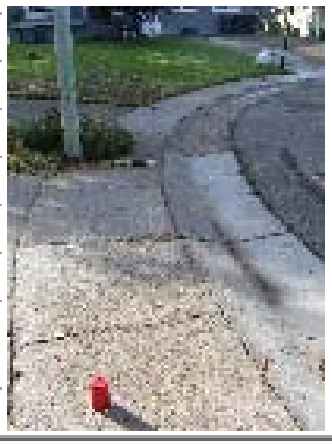
Location: Spring Oaks Ct - South
X Coordinate: -121.29728
Y Coordinate: 38.71268
Barrier Area: Sidewalks
Barrier Type: Cross Slope - Existing (5.0% or more)
Code Ref: CBC 1133B.7.1 and ADA/ABA 303.3
As Built Meas: 216 Quantity: LF
Description: Cross slope exceeds 2.0% (5.0% or more)
As Built Desc: 6.1% cross slope
Solution: Demolish existing and construct new route
Bar. Severity: 1 Necessary Cost Estimate: $27,000.00 Status:
Implementation Priority: 4 Facility Function:
Implementation Phase: Implementation Date:
Official Responsible:
Notes:

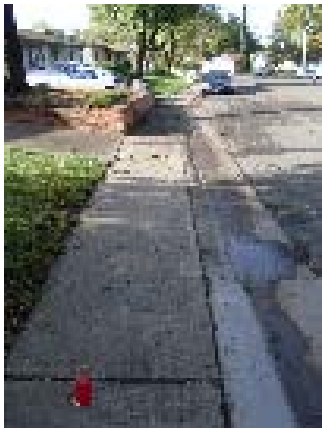
Field Date: 10/25/2010 Report Date: 10/25/2010 Barrier #: 1437A
Location: Lesser Wy - East
X Coordinate: -121.29833
Y Coordinate: 38.71211
Barrier Area: Sidewalks
Barrier Type: Cross Slope - Existing (5.0% or more)
Code Ref: CBC 1133B.7.1 and ADA/ABA 303.3
As Built Meas: 246 Quantity: LF
Description: Cross slope exceeds 2.0% (5.0% or more)
As Built Desc: 6.0% cross slope
Solution: Demolish existing and construct new route
Bar. Severity: 1 Necessary Cost Estimate: $30,750.00 Status:
Implementation Priority: 4 Facility Function:
Implementation Phase: Implementation Date:
Official Responsible:
Notes:

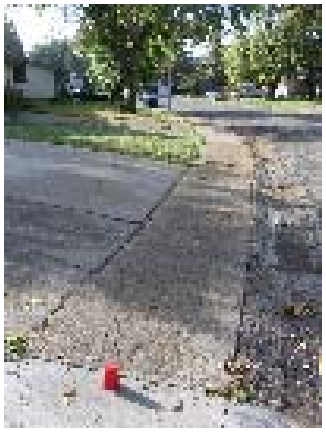
Field Date: 10/25/2010 Report Date: 10/25/2010 Barrier #: 1438
Location: Lesser Wy - East
X Coordinate: -121.29921
Y Coordinate: 38.71146
Barrier Area: Sidewalks
Barrier Type: Cross Slope - Existing (5.0% or more)
Code Ref: CBC 1133B.7.1 and ADA/ABA 303.3
As Built Meas: 303 Quantity: LF
Description: Cross slope exceeds 2.0% (5.0% or more)
As Built Desc: 8.9% cross slope
Solution: Demolish existing and construct new route
Bar. Severity: 1 Necessary Cost Estimate: $37,875.00 Status:
Implementation Priority: 4 Facility Function:
Implementation Phase: Implementation Date:
Official Responsible:
Notes:

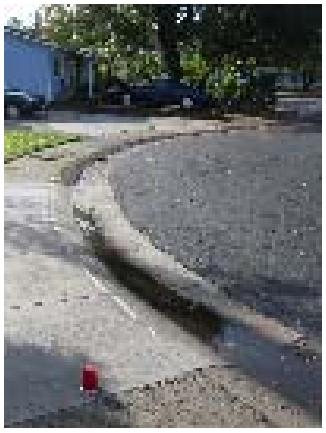
Field Date: 10/25/2010 Report Date: 10/25/2010 Barrier #: 1442

Location: Julia Ct - East
X Coordinate: -121.29818
Y Coordinate: 38.71122
Barrier Area: Sidewalks
Barrier Type: Cross Slope - Existing (4.1% to 4.9%)
Code Ref: CBC 1133B.7.1.3 and ADA/ABA 403.3
As Built Meas: 194 Quantity: LF
Description: Cross slope exceeds 2.0% (4.1% to 4.9%)
As Built Desc: 4.3% cross slope
Solution: Demolish existing and construct new route
Bar. Severity: 2 Recommended Cost Estimate: $24,250.00 Status:
Implementation Priority: 4 Facility Function:
Implementation Phase: Implementation Date:
Official Responsible:
Notes:

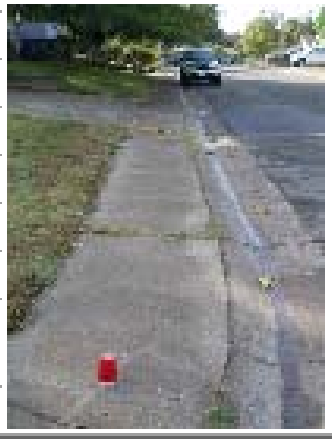
Location: Dogwood Wy - East
X Coordinate: -121.29726
Y Coordinate: 38.71151
Barrier Area: Sidewalks
Barrier Type: Cross Slope - Existing (4.1% to 4.9%)
Code Ref: CBC 1133B.7.1.3 and ADA/ABA 403.3
As Built Meas: 314 Quantity: LF
Description: Cross slope exceeds 2.0% (4.1% to 4.9%)
As Built Desc: 4.9% cross slope
Solution: Demolish existing and construct new route
Bar. Severity: 2 Recommended Cost Estimate: $39,250.00 Status:
Implementation Priority: 4 Facility Function:
Implementation Phase: Implementation Date:
Official Responsible:
Notes:

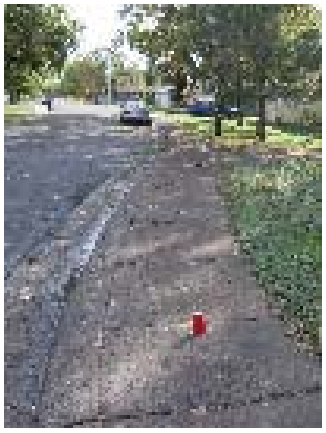
Field Date: 10/25/2010 Report Date: 10/25/2010 Barrier #: 1451

Location: Brook Dale Dr - South
X Coordinate: -121.29652
Y Coordinate: 38.70985
Barrier Area: Sidewalks
Barrier Type: Cross Slope - Existing (5.0% or more)
Code Ref: CBC 1133B.7.1 and ADA/ABA 303.3
As Built Meas: 102 Quantity: LF
Description: Cross slope exceeds 2.0% (5.0% or more)
As Built Desc: 6.2% cross slope
Solution: Demolish existing and construct new route
Bar. Severity: 1 Necessary Cost Estimate: $12,750.00 Status:
Implementation Priority: 4 Facility Function:
Implementation Phase: Implementation Date:
Official Responsible:
Notes:

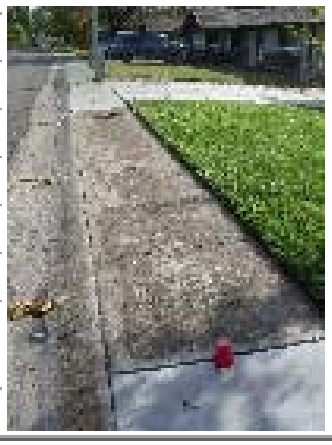
Field Date: 10/25/2010 Report Date: 10/25/2010 Barrier #: 1452

Location: Brook Dale Dr - South
X Coordinate: -121.29571
Y Coordinate: 38.70975
Barrier Area: Sidewalks
Barrier Type: Cross Slope - Existing (5.0% or more)
Code Ref: CBC 1133B.7.1 and ADA/ABA 303.3
As Built Meas: 71 Quantity: LF
Description: Cross slope exceeds 2.0% (5.0% or more)
As Built Desc: 6.4% cross slope
Solution: Demolish existing and construct new route
Bar. Severity: 1 Necessary Cost Estimate: $8,875.00 Status:
Implementation Priority: 4 Facility Function:
Implementation Phase: Implementation Date:
Official Responsible:
Notes:

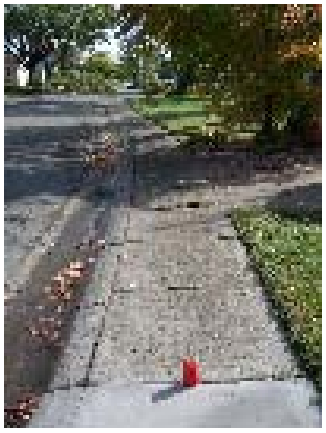
Field Date: 10/25/2010 Report Date: 10/25/2010 Barrier #: 1453A

Location: Brook Dale Dr - South
X Coordinate: -121.29508
Y Coordinate: 38.70975
Barrier Area: Sidewalks
Barrier Type: Cross Slope - Existing (5.0% or more)
Code Ref: CBC 1133B.7.1 and ADA/ABA 303.3
As Built Meas: 696 Quantity: LF
Description: Cross slope exceeds 2.0% (5.0% or more)
As Built Desc: 8.2% cross slope
Solution: Demolish existing and construct new route
Bar. Severity: 1 Necessary Cost Estimate: $87,000.00 Status:
Implementation Priority: 4 Facility Function:
Implementation Phase: Implementation Date:
Official Responsible:
Notes:

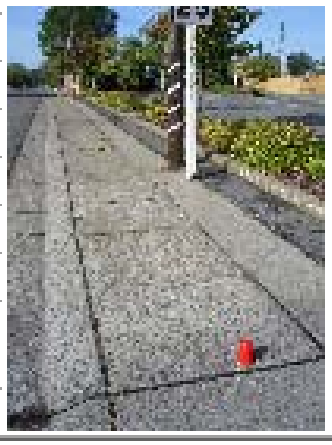
Field Date: 10/25/2010 Report Date: 10/25/2010 Barrier #: 1476

Location: Grand Oaks Blvd - North
X Coordinate: -121.29136
Y Coordinate: 38.71064
Barrier Area: Sidewalks
Barrier Type: Cross Slope - Existing (5.0% or more)
Code Ref: CBC 1133B.7.1 and ADA/ABA 303.3
As Built Meas: 174 Quantity: LF
Description: Cross slope exceeds 2.0% (5.0% or more)
As Built Desc: 5.4% cross slope
Solution: Demolish existing and construct new route
Bar. Severity: 1 Necessary Cost Estimate: $21,750.00 Status:
Implementation Priority: 4 Facility Function:
Implementation Phase: Implementation Date:
Official Responsible:
Notes:

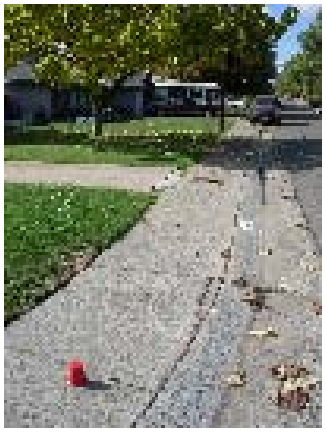
Field Date: 10/25/2010 Report Date: 10/25/2010 Barrier #: 1487A
Location: Morningside Wy - South
X Coordinate: -121.29276
Y Coordinate: 38.71128
Barrier Area: Sidewalks
Barrier Type: Cross Slope - Existing (5.0% or more)
Code Ref: CBC 1133B.7.1 and ADA/ABA 303.3
As Built Meas: 1013 Quantity: LF
Description: Cross slope exceeds 2.0% (5.0% or more)
As Built Desc: 7.4% cross slope
Solution: Demolish existing and construct new route
Bar. Severity: 1 Necessary Cost Estimate: $126,625.00 Status:
Implementation Priority: 4 Facility Function:
Implementation Phase: Implementation Date:
Official Responsible:
Notes:

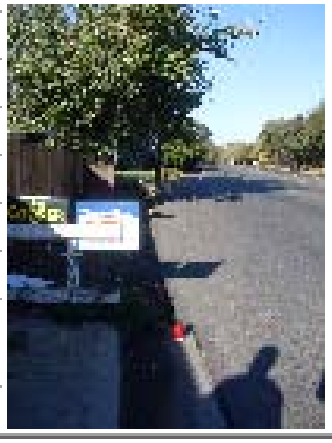
Field Date: 10/26/2010 Report Date: 10/26/2010 Barrier #: 1593

Location: Antelope Rd - South
X Coordinate: -121.29149
Y Coordinate: 38.70653
Barrier Area: Sidewalks
Barrier Type: No sidewalk
Code Ref: CBC 1133B.7.1.3 and ADA/ABA 403.3
As Built Meas: 860 Quantity: LF
Description: No pedestrian route provided
As Built Desc: No sidewalk provided
Solution: Construct new firm and stable pedestrian route
Bar. Severity: 1 Necessary Cost Estimate: $86,000.00 Status:
Implementation Priority: 1 Facility Function:
Implementation Phase: Implementation Date:
Official Responsible:
Notes:

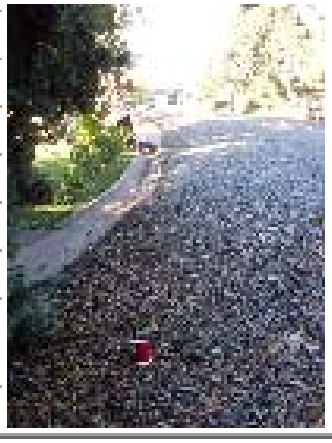
Field Date: 10/26/2010 Report Date: 10/26/2010 Barrier #: 1598

Location: Muth Ln - South
X Coordinate: -121.2932
Y Coordinate: 38.70577
Barrier Area: Sidewalks
Barrier Type: No sidewalk
Code Ref: CBC 1133B.7.1.3 and ADA/ABA 403.3
As Built Meas: 360 Quantity: LF
Description: No pedestrian route provided
As Built Desc: No sidewalk provided
Solution: Construct new firm and stable pedestrian route
Bar. Severity: 1 Necessary Cost Estimate: $36,000.00 Status:
Implementation Priority: 4 Facility Function:
Implementation Phase: Implementation Date:
Official Responsible:
Notes:

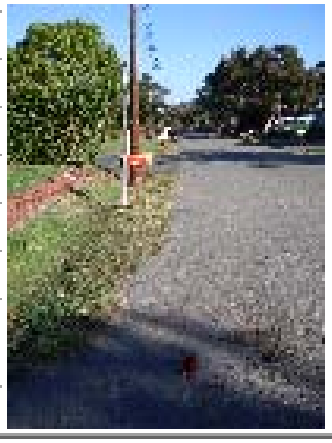
Field Date: 10/26/2010 Report Date: 10/26/2010 Barrier #: 1599

Location: Oakwood Ln - West
X Coordinate: -121.29449
Y Coordinate: 38.70586
Barrier Area: Sidewalks
Barrier Type: No sidewalk
Code Ref: CBC 1133B.7.1.3 and ADA/ABA 403.3
As Built Meas: 533 Quantity: LF
Description: No pedestrian route provided
As Built Desc: No sidewalk provided
Solution: Construct new firm and stable pedestrian route
Bar. Severity: 1 Necessary Cost Estimate: $53,300.00 Status:
Implementation Priority: 4 Facility Function:
Implementation Phase: Implementation Date:
Official Responsible:
Notes:

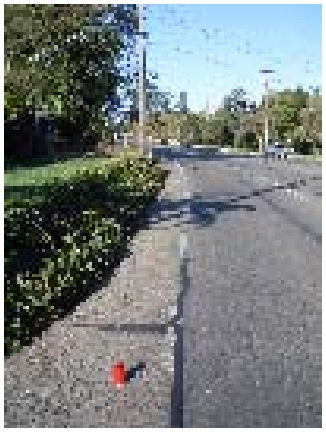
Field Date: 10/26/2010 Report Date: 10/26/2010 Barrier #: 1600

Location: Antelope Rd - South
X Coordinate: -121.29451
Y Coordinate: 38.70732
Barrier Area: Sidewalks
Barrier Type: Shoulder Cross Slope - Existing (4.1% to 4.9%)
Code Ref: CBC 1133B.7.1.3 and ADA/ABA 403.3
As Built Meas: 496 Quantity: LF
Description: Cross slope exceeds 2.0% (4.1% to 4.9%)
As Built Desc: 4.3% cross slope
Solution: Demolish existing and construct new pedestrian route
Bar. Severity: 2 Recommended Cost Estimate: $62,000.00 Status:
Implementation Priority: 1 Facility Function:
Implementation Phase: Implementation Date:
Official Responsible:
Notes:

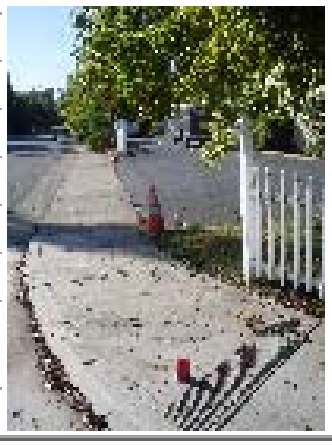
Location: Poplar Ave - West
X Coordinate: -121.29889
Y Coordinate: 38.70726
Barrier Area: Sidewalks
Barrier Type: No sidewalk (end of path)
Code Ref: CBC 1133B.8.5
As Built Meas: 1 Quantity: JOB
Description: Sidewalk route ends and no opposite sidewalk exists
As Built Desc: Directional sign lacking forcing pedestrians to retrace their steps
Solution: Provide directional sign at junction in route to allow travel in shoulder
Bar. Severity: 1 Necessary Cost Estimate: $100.00 Status:
Implementation Priority: 4 Facility Function:
Implementation Phase: Implementation Date:
Official Responsible:
Notes:

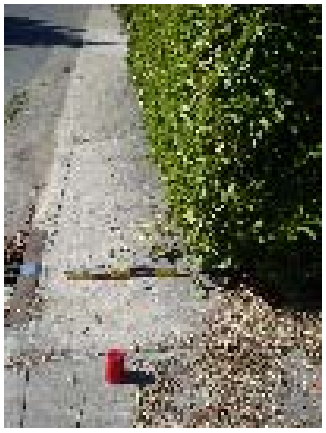
Field Date: 10/26/2010 Report Date: 10/26/2010 Barrier #: 1639B

Location: Pratt Ave - North
X Coordinate: -121.29202
Y Coordinate: 38.7033
Barrier Area: Sidewalks
Barrier Type: Clear Width - Existing (≤31” or less)
Code Ref: CBC 1133B.7.1
As Built Meas: 20 Quantity: LF
Description: Pedestrian route is not min. 48" wide (≤31” or less)
As Built Desc: 30" clear width due to foliage
Solution: Trim foliage to provide min. 48" clear width
Bar. Severity: 1 Necessary Cost Estimate: $0.00 Status:
Implementation Priority: 4 Facility Function:
Implementation Phase: Implementation Date:
Official Responsible:
Notes:

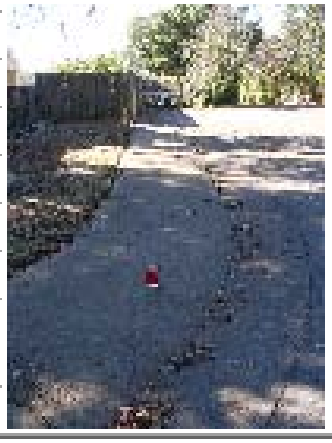
Field Date: 10/26/2010 Report Date: 10/26/2010 Barrier #: 1646

Location: Sara Lynn Wy - West
X Coordinate: -121.29252
Y Coordinate: 38.7047
Barrier Area: Sidewalks
Barrier Type: No sidewalk (end of path)
Code Ref: CBC 1133B.8.5
As Built Meas: 1 Quantity: JOB
Description: Sidewalk route ends and no opposite sidewalk exists
As Built Desc: Directional sign lacking forcing pedestrians to retrace their steps
Solution: Provide directional sign at junction in route to allow travel in shoulder
Bar. Severity: 1 Necessary Cost Estimate: $100.00 Status:
Implementation Priority: 4 Facility Function:
Implementation Phase: Implementation Date:
Official Responsible:
Notes:

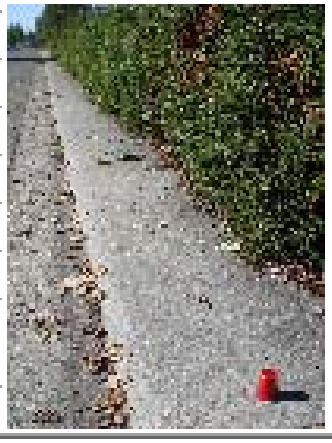
Location: Pratt Wy - North
X Coordinate: -121.29309
Y Coordinate: 38.70329
Barrier Area: Sidewalks
Barrier Type: Cross Slope - Existing (5.0% or more)
Code Ref: CBC 1133B.7.1 and ADA/ABA 303.3
As Built Meas: 26 Quantity: LF
Description: Cross slope exceeds 2.0% (5.0% or more)
As Built Desc: 8.1% cross slope
Solution: Demolish existing and construct new route
Bar. Severity: 1 Necessary Cost Estimate: $3,250.00 Status:
Implementation Priority: 4 Facility Function:
Implementation Phase: Implementation Date:
Official Responsible:
Notes:

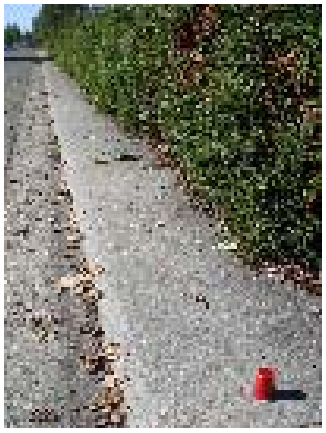
Field Date: 10/26/2010 Report Date: 10/26/2010 Barrier #: 1649A

Location: Pratt Wy - North
X Coordinate: -121.29313
Y Coordinate: 38.7033
Barrier Area: Sidewalks
Barrier Type: Cross Slope - Existing (4.1% to 4.9%)
Code Ref: CBC 1133B.7.1.3 and ADA/ABA 403.3
As Built Meas: 489 Quantity: LF
Description: Cross slope exceeds 2.0% (4.1% to 4.9%)
As Built Desc: 4.9% cross slope
Solution: Demolish existing and construct new route
Bar. Severity: 2 Recommended Cost Estimate: $61,125.00 Status:
Implementation Priority: 4 Facility Function:
Implementation Phase: Implementation Date:
Official Responsible:
Notes:

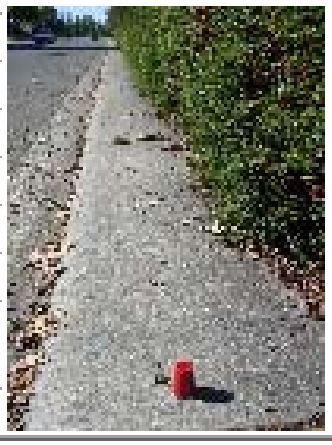
Location: Pratt Wy - North
X Coordinate: -121.29313
Y Coordinate: 38.7033
Barrier Area: Sidewalks
Barrier Type: Clear Width - Existing (32” to 35”)
Code Ref: CBC 1133B.7.1
As Built Meas: 193 Quantity: LF
Description: Pedestrian route is not min. 48" wide (32” to 35”)
As Built Desc: 32" clear width due to foliage
Solution: Trim foliage to provide min. 48" clear width
Bar. Severity: 1 Necessary Cost Estimate: $0.00 Status:
Implementation Priority: 4 Facility Function:
Implementation Phase: Implementation Date:
Official Responsible:
Notes:

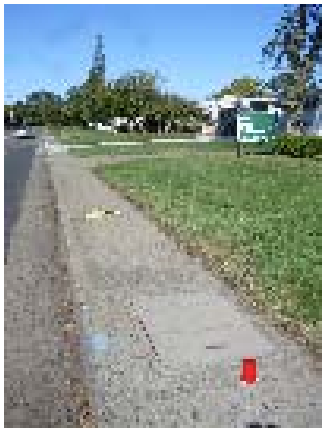
Field Date: 10/26/2010 Report Date: 10/26/2010 Barrier #: 1667
Location: Lauppe Ln - East
X Coordinate: -121.29628
Y Coordinate: 38.70507
Barrier Area: Sidewalks
Barrier Type: Driveway - Existing (5.0% or more)
Code Ref: CBC 1133B.7.1.3 and ADA/ABA 403.3
As Built Meas: 44 Quantity: LF
Description: Driveway cross slope exceeds 2.0% (5.0% or more)
As Built Desc: 7.0% cross slope
Solution: Provide min. 48" wide level walkway through driveway
Bar. Severity: 4 Low Severity Cost Estimate: $5,500.00 Status:
Implementation Priority: 2 Facility Function:
Implementation Phase: Implementation Date:
Official Responsible:
Notes:

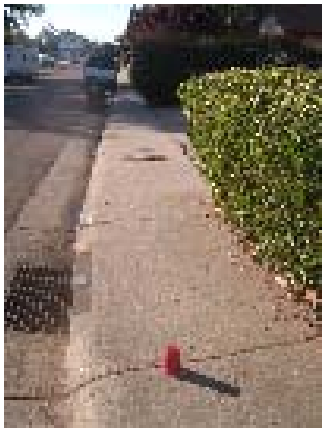
Field Date: 10/27/2010 Report Date: 10/27/2010 Barrier #: 1689
Location: Pratt Ave and Ripplewood Ct - Corner D
X Coordinate: -121.29187
Y Coordinate: 38.70317
Barrier Area: Curb Ramps
Barrier Type: No Curb Ramp - Depressed Existing Curb
Code Ref: CBC 1127B.5.3 and ADA/ABA 406.2
As Built Meas: 1 Quantity: EACH
Description: No compliant curb cut at corner (intersection)
As Built Desc: 12.2% running slope at deprssed area
Solution: Demolish existing and construct curb cut
Bar. Severity: 1 Necessary Cost Estimate: $2,500.00 Status:
Implementation Priority: 4 Facility Function:
Implementation Phase: Implementation Date:
Official Responsible:
Notes: Two - way intersection corners C,D

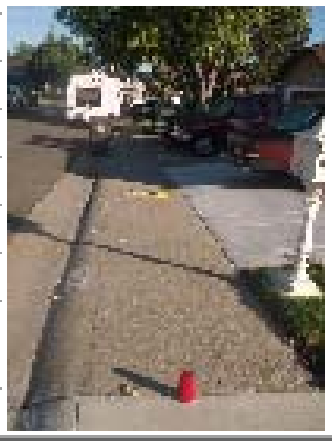
Field Date: 10/27/2010 Report Date: 10/27/2010 Barrier #: 1692

Location: Ripplewood Ct - East
X Coordinate: -121.2918
Y Coordinate: 38.7026
Barrier Area: Sidewalks
Barrier Type: Cross Slope - Existing (5.0% or more)
Code Ref: CBC 1133B.7.1 and ADA/ABA 303.3
As Built Meas: 207 Quantity: LF
Description: Cross slope exceeds 2.0% (5.0% or more)
As Built Desc: 5.0% cross slope
Solution: Demolish existing and construct new route
Bar. Severity: 1 Necessary Cost Estimate: $25,875.00 Status:
Implementation Priority: 4 Facility Function:
Implementation Phase: Implementation Date:
Official Responsible:
Notes:

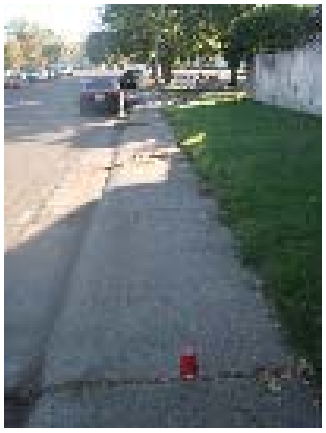
Field Date: 10/27/2010 Report Date: 10/27/2010 Barrier #: 1693

Location: Pratt Ave - South
X Coordinate: -121.29161
Y Coordinate: 38.7032
Barrier Area: Sidewalks
Barrier Type: Cross Slope - Existing (4.1% to 4.9%)
Code Ref: CBC 1133B.7.1.3 and ADA/ABA 403.3
As Built Meas: 67 Quantity: LF
Description: Cross slope exceeds 2.0% (4.1% to 4.9%)
As Built Desc: 4.9% cross slope
Solution: Demolish existing and construct new route
Bar. Severity: 2 Recommended Cost Estimate: $8,375.00 Status:
Implementation Priority: 4 Facility Function:
Implementation Phase: Implementation Date:
Official Responsible:
Notes:

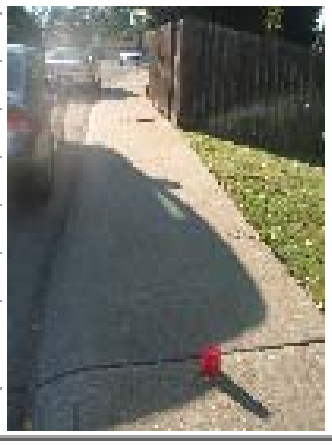
Location: Sadro St - West
X Coordinate: -121.29273
Y Coordinate: 38.70206
Barrier Area: Sidewalks
Barrier Type: Cross Slope - Existing (4.1% to 4.9%)
Code Ref: CBC 1133B.7.1.3 and ADA/ABA 403.3
As Built Meas: 203 Quantity: LF
Description: Cross slope exceeds 2.0% (4.1% to 4.9%)
As Built Desc: 4.9% cross slope
Solution: Demolish existing and construct new route
Bar. Severity: 2 Recommended Cost Estimate: $25,375.00 Status:
Implementation Priority: 4 Facility Function:
Implementation Phase: Implementation Date:
Official Responsible:
Notes:

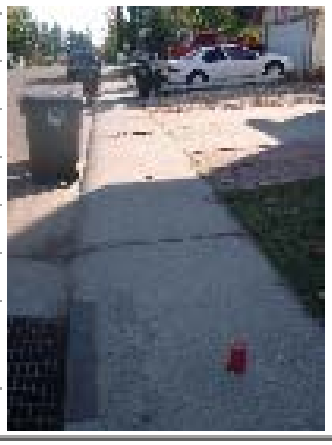
Field Date: 10/27/2010 Report Date: 10/27/2010 Barrier #: 1713

Location: Pimienta Dr - South
X Coordinate: -121.29475
Y Coordinate: 38.7021
Barrier Area: Sidewalks
Barrier Type: Cross Slope - Existing (5.0% or more)
Code Ref: CBC 1133B.7.1 and ADA/ABA 303.3
As Built Meas: 559 Quantity: LF
Description: Cross slope exceeds 2.0% (5.0% or more)
As Built Desc: 5.8% cross slope
Solution: Demolish existing and construct new route
Bar. Severity: 1 Necessary Cost Estimate: $69,875.00 Status:
Implementation Priority: 4 Facility Function:
Implementation Phase: Implementation Date:
Official Responsible:
Notes:

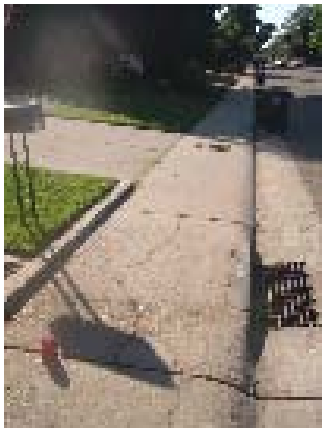
Field Date: 10/27/2010 Report Date: 10/27/2010 Barrier #: 1716B
Location: Carriage Dr - East
X Coordinate: -121.2949
Y Coordinate: 38.70272
Barrier Area: Sidewalks
Barrier Type: Clear Width - Existing (≤31" or less)
Code Ref: CBC 1133B.7.1
As Built Meas: 4 Quantity: LF
Description: Pedestrian route is not min. 48" wide (≤31" or less)
As Built Desc: 30" clear width due to pole
Solution: Demolish existing and construct new route
Bar. Severity: 1 Necessary Cost Estimate: $500.00 Status:
Implementation Priority: 3 Facility Function:
Implementation Phase: Implementation Date:
Official Responsible:
Notes:

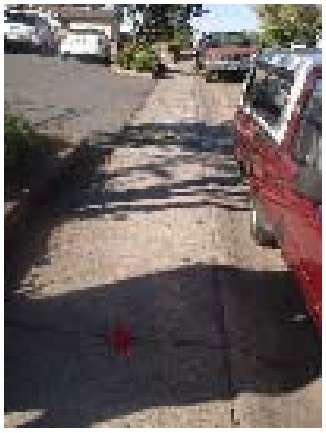
Field Date: 10/27/2010 Report Date: 10/27/2010 Barrier #: 1723
Location: Kanai Ave - South
X Coordinate: -121.29082
Y Coordinate: 38.70136
Barrier Area: Sidewalks
Barrier Type: Driveway - Existing (5.0% or more)
Code Ref: CBC 1133B.7.1.3 and ADA/ABA 403.3
As Built Meas: 45 Quantity: LF
Description: Driveway cross slope exceeds 2.0% (5.0% or more)
As Built Desc: 8.6% cross slope
Solution: Provide min. 48" wide level walkway through driveway
Bar. Severity: 4 Low Severity Cost Estimate: $5,625.00 Status:
Implementation Priority: 4 Facility Function:
Implementation Phase: Implementation Date:
Official Responsible:
Notes:

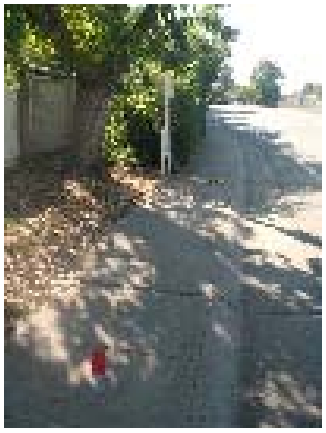
Field Date: 10/27/2010 Report Date: 10/27/2010 Barrier #: 1726
Location: Kanai Ave - South
X Coordinate: -121.29453
Y Coordinate: 38.70135
Barrier Area: Sidewalks
Barrier Type: Abrupt Change in Level - > 1/2"
Code Ref: CBC 1133B.7.1 and ADA/ABA 303.3
As Built Meas: 4 Quantity: LF
Description: Change in level greater than 1/2"
As Built Desc: 1/2" lip in sidewalk surface
Solution: Grind or repair sidewalk to remove trip hazard
Bar. Severity: 1 Necessary Cost Estimate: $1,000.00 Status:
Implementation Priority: 4 Facility Function:
Implementation Phase: Implementation Date:
Official Responsible:
Notes:

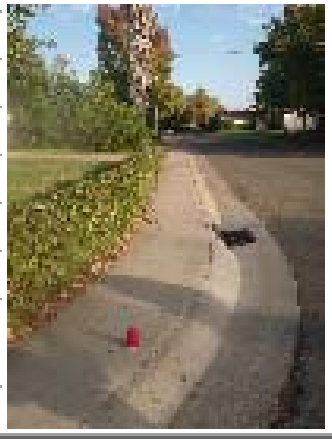
Field Date: 10/28/2010 Report Date: 10/28/2010 Barrier #: 1740

Location: Grandball Wy - West
X Coordinate: -121.29407
Y Coordinate: 38.69771
Barrier Area: Sidewalks
Barrier Type: No sidewalk (end of path)
Code Ref: CBC 1133B.8.5
As Built Meas: 1 Quantity: JOB
Description: Sidewalk route ends and no opposite sidewalk exists
As Built Desc: Directional sign lacking forcing pedestrians to retrace their steps
Solution: Provide directional sign at junction in route to allow travel in shoulder
Bar. Severity: 1 Necessary Cost Estimate: $100.00 Status:
Implementation Priority: 4 Facility Function:
Implementation Phase: Implementation Date:
Official Responsible:
Notes:

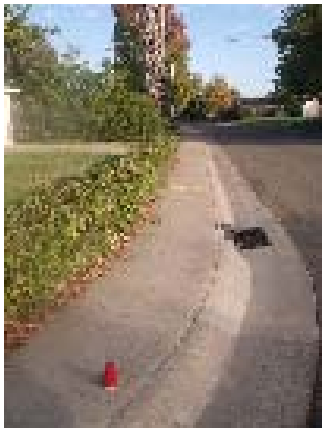
Field Date: 10/28/2010 Report Date: 10/28/2010 Barrier #: 1741A

Location: Grandball Wy - West
X Coordinate: -121.29407
Y Coordinate: 38.69775
Barrier Area: Sidewalks
Barrier Type: Cross Slope - Existing (5.0% or more)
Code Ref: CBC 1133B.7.1 and ADA/ABA 303.3
As Built Meas: 652 Quantity: LF
Description: Cross slope exceeds 2.0% (5.0% or more)
As Built Desc: 7.3% cross slope
Solution: Demolish existing and construct new route
Bar. Severity: 1 Necessary Cost Estimate: $81,500.00 Status:
Implementation Priority: 4 Facility Function:
Implementation Phase: Implementation Date:
Official Responsible:
Notes:

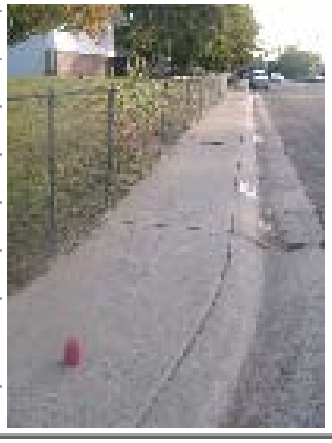
Location: Kingsman Ave - North
X Coordinate: -121.29385
Y Coordinate: 38.6977
Barrier Area: Sidewalks
Barrier Type: Cross Slope - Existing (5.0% or more)
Code Ref: CBC 1133B.7.1 and ADA/ABA 303.3
As Built Meas: 313 Quantity: LF
Description: Cross slope exceeds 2.0% (5.0% or more)
As Built Desc: 5.2% cross slope
Solution: Demolish existing and construct new route
Bar. Severity: 1 Necessary Cost Estimate: $39,125.00 Status:
Implementation Priority: 4 Facility Function:
Implementation Phase: Implementation Date:
Official Responsible:
Notes:

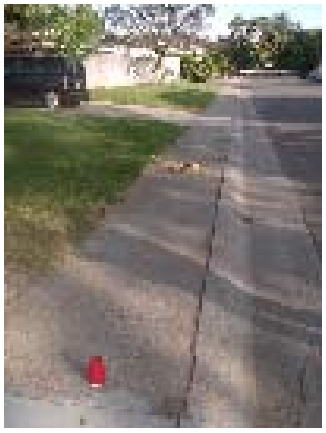
Field Date: 10/28/2010 Report Date: 10/28/2010 Barrier #: 1749
Location: Fairytale St - West
X Coordinate: -121.29279
Y Coordinate: 38.69774
Barrier Area: Sidewalks
Barrier Type: Clear Width - Existing (≤31" or less)
Code Ref: CBC 1133B.7.1
As Built Meas: 26 Quantity: LF
Description: Pedestrian route is not min. 48" wide (≤31" or less)
As Built Desc: 30" clear width due to foliage
Solution: Trim foliage to provide min. 48" clear width
Bar. Severity: 1 Necessary Cost Estimate: $0.00 Status:
Implementation Priority: 4 Facility Function:
Implementation Phase: Implementation Date:
Official Responsible:
Notes:

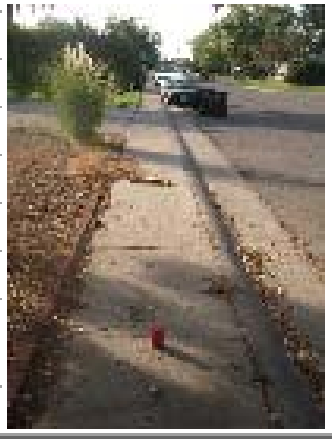
Field Date: 10/28/2010 Report Date: 10/28/2010 Barrier #: 1755

Location: Fairytale St - East
X Coordinate: -121.29262
Y Coordinate: 38.69941
Barrier Area: Sidewalks
Barrier Type: Cross Slope - Existing (5.0% or more)
Code Ref: CBC 1133B.7.1 and ADA/ABA 303.3
As Built Meas: 405 Quantity: LF
Description: Cross slope exceeds 2.0% (5.0% or more)
As Built Desc: 5.0% cross slope
Solution: Demolish existing and construct new route
Bar. Severity: 1 Necessary Cost Estimate: $50,625.00 Status:
Implementation Priority: 4 Facility Function:
Implementation Phase: Implementation Date:
Official Responsible:
Notes:

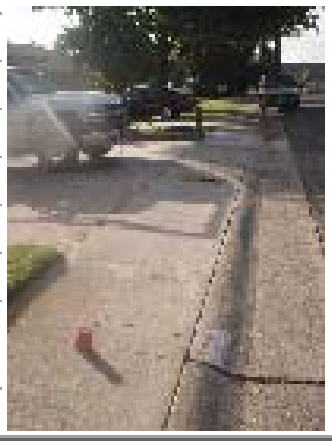
Field Date: 10/28/2010 Report Date: 10/28/2010 Barrier #: 1762

Location: Fairytale St - East
X Coordinate: -121.29259
Y Coordinate: 38.69805
Barrier Area: Sidewalks
Barrier Type: Cross Slope - Existing (5.0% or more)
Code Ref: CBC 1133B.7.1 and ADA/ABA 303.3
As Built Meas: 167 Quantity: LF
Description: Cross slope exceeds 2.0% (5.0% or more)
As Built Desc: 7.0% cross slope
Solution: Demolish existing and construct new route
Bar. Severity: 1 Necessary Cost Estimate: $20,875.00 Status:
Implementation Priority: 4 Facility Function:
Implementation Phase: Implementation Date:
Official Responsible:
Notes:

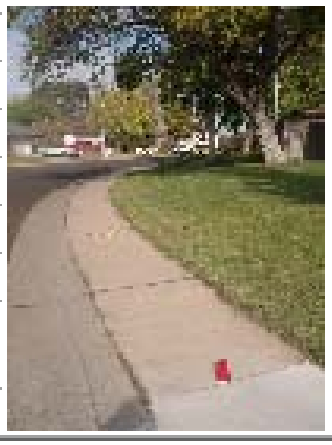
Field Date: 10/28/2010 Report Date: 10/28/2010 Barrier #: 1784

Location: Brocade Dr - East
X Coordinate: -121.29878
Y Coordinate: 38.69943
Barrier Area: Sidewalks
Barrier Type: Cross Slope - Existing (5.0% or more)
Code Ref: CBC 1133B.7.1 and ADA/ABA 303.3
As Built Meas: 325 Quantity: LF
Description: Cross slope exceeds 2.0% (5.0% or more)
As Built Desc: 5.9% cross slope
Solution: Demolish existing and construct new route
Bar. Severity: 1 Necessary Cost Estimate: $40,625.00 Status:
Implementation Priority: 4 Facility Function:
Implementation Phase: Implementation Date:
Official Responsible:
Notes:

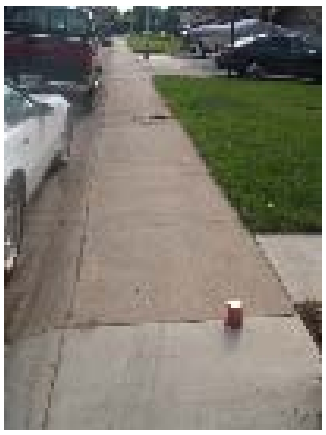
Field Date: 10/28/2010 Report Date: 10/28/2010 Barrier #: 1785

Location: Brocade Dr - West
X Coordinate: -121.29885
Y Coordinate: 38.69935
Barrier Area: Sidewalks
Barrier Type: Cross Slope - Existing (5.0% or more)
Code Ref: CBC 1133B.7.1 and ADA/ABA 303.3
As Built Meas: 534 Quantity: LF
Description: Cross slope exceeds 2.0% (5.0% or more)
As Built Desc: 5.5% cross slope
Solution: Demolish existing and construct new route
Bar. Severity: 1 Necessary Cost Estimate: $66,750.00 Status:
Implementation Priority: 4 Facility Function:
Implementation Phase: Implementation Date:
Official Responsible:
Notes:

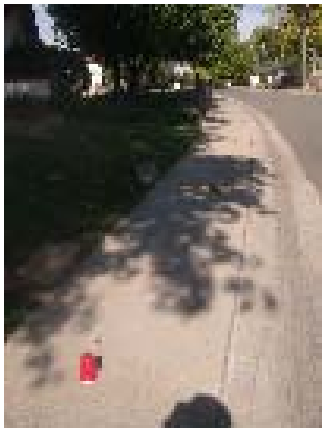
Field Date: 10/28/2010 Report Date: 10/28/2010 Barrier #: 1796
Location: Candlelight Wy - West
X Coordinate: -121.29588
Y Coordinate: 38.6981
Barrier Area: Sidewalks
Barrier Type: Cross Slope - Existing (5.0% or more)
Code Ref: CBC 1133B.7.1 and ADA/ABA 303.3
As Built Meas: 637 Quantity: LF
Description: Cross slope exceeds 2.0% (5.0% or more)
As Built Desc: 6.0% cross slope
Solution: Demolish existing and construct new route
Bar. Severity: 1 Necessary Cost Estimate: $79,625.00 Status:
Implementation Priority: 4 Facility Function:
Implementation Phase: Implementation Date:
Official Responsible:
Notes:

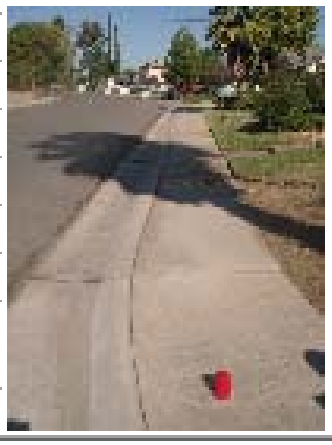
Field Date: 10/28/2010 Report Date: 10/28/2010 Barrier #: 1801

Location: Candlelight Wy - East
X Coordinate: -121.29594
Y Coordinate: 38.69718
Barrier Area: Sidewalks
Barrier Type: Cross Slope - Existing (5.0% or more)
Code Ref: CBC 1133B.7.1 and ADA/ABA 303.3
As Built Meas: 550 Quantity: LF
Description: Cross slope exceeds 2.0% (5.0% or more)
As Built Desc: 8.5% cross slope
Solution: Demolish existing and construct new route
Bar. Severity: 1 Necessary Cost Estimate: $68,750.00 Status:
Implementation Priority: 4 Facility Function:
Implementation Phase: Implementation Date:
Official Responsible:
Notes:

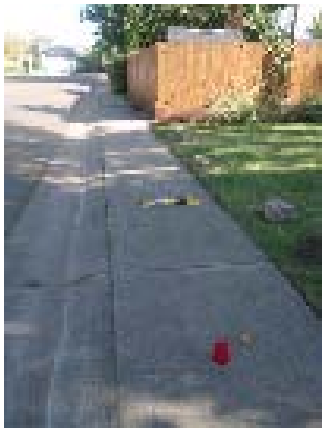
Field Date: 10/28/2010 Report Date: 10/28/2010 Barrier #: 1802

Location: Footman Wy - South
X Coordinate: -121.29584
Y Coordinate: 38.69872
Barrier Area: Sidewalks
Barrier Type: Cross Slope - Existing (5.0% or more)
Code Ref: CBC 1133B.7.1 and ADA/ABA 303.3
As Built Meas: 180 Quantity: LF
Description: Cross slope exceeds 2.0% (5.0% or more)
As Built Desc: 6.0% cross slope
Solution: Demolish existing and construct new route
Bar. Severity: 1 Necessary Cost Estimate: $22,500.00 Status:
Implementation Priority: 4 Facility Function:
Implementation Phase: Implementation Date:
Official Responsible:
Notes:

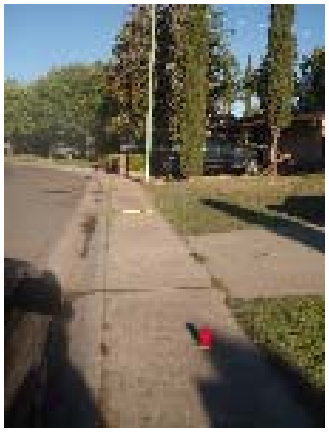
Location: Calvin Dr - North
X Coordinate: -121.2991
Y Coordinate: 38.6987
Barrier Area: Sidewalks
Barrier Type: Cross Slope - Existing (5.0% or more)
Code Ref: CBC 1133B.7.1 and ADA/ABA 303.3
As Built Meas: 149 Quantity: LF
Description: Cross slope exceeds 2.0% (5.0% or more)
As Built Desc: 5.2% cross slope
Solution: Demolish existing and construct new route
Bar. Severity: 1 Necessary Cost Estimate: $18,625.00 Status:
Implementation Priority: 4 Facility Function:
Implementation Phase: Implementation Date:
Official Responsible:
Notes:

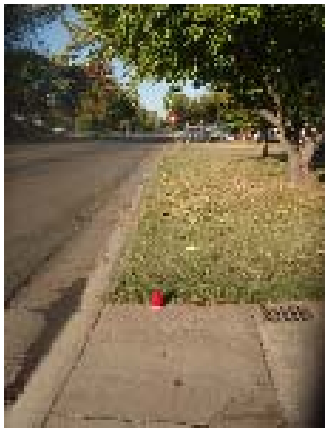
Field Date: 11/1/2010 Report Date: 11/1/2010 Barrier #: 1806
Location: Calvin Dr - North
X Coordinate: -121.29944
Y Coordinate: 38.69889
Barrier Area: Sidewalks
Barrier Type: No sidewalk
Code Ref: CBC 1133B.7.1.3 and ADA/ABA 403.3
As Built Meas: 153 Quantity: LF
Description: No pedestrian route provided
As Built Desc: No sidewalk provided
Solution: Construct new firm and stable pedestrian route
Bar. Severity: 1 Necessary Cost Estimate: $15,300.00 Status:
Implementation Priority: 4 Facility Function:
Implementation Phase: Implementation Date:
Official Responsible:
Notes:

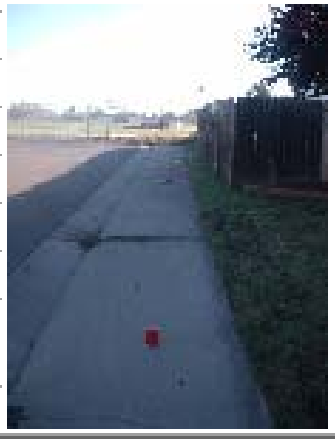
Location: Volta Wy - South
X Coordinate: -121.29978
Y Coordinate: 38.70035
Barrier Area: Sidewalks
Barrier Type: Cross Slope - Existing (4.1% to 4.9%)
Code Ref: CBC 1133B.7.1.3 and ADA/ABA 403.3
As Built Meas: 74 Quantity: LF
Description: Cross slope exceeds 2.0% (4.1% to 4.9%)
As Built Desc: 4.6% cross slope
Solution: Demolish existing and construct new route
Bar. Severity: 2 Recommended Cost Estimate: $9,250.00 Status:
Implementation Priority: 4 Facility Function:
Implementation Phase: Implementation Date:
Official Responsible:
Notes:

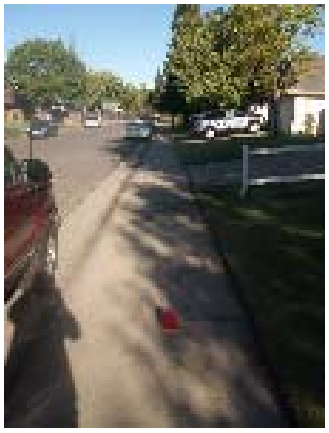
Location: Cessna Dr - East
X Coordinate: -121.29993
Y Coordinate: 38.70058
Barrier Area: Sidewalks
Barrier Type: Cross Slope - Existing (4.1% to 4.9%)
Code Ref: CBC 1133B.7.1.3 and ADA/ABA 403.3
As Built Meas: 107 Quantity: LF
Description: Cross slope exceeds 2.0% (4.1% to 4.9%)
As Built Desc: 4.2% cross slope
Solution: Demolish existing and construct new route
Bar. Severity: 2 Recommended Cost Estimate: $13,375.00 Status:
Implementation Priority: 4 Facility Function:
Implementation Phase: Implementation Date:
Official Responsible:
Notes:

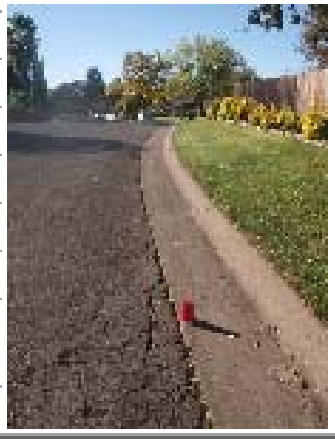
Field Date: 11/1/2010 Report Date: 11/1/2010 Barrier #: 1820

Location: Cessna Dr - West
X Coordinate: -121.29999
Y Coordinate: 38.70024
Barrier Area: Sidewalks
Barrier Type: No sidewalk
Code Ref: CBC 1133B.7.1.3 and ADA/ABA 403.3
As Built Meas: 170 Quantity: LF
Description: No pedestrian route provided
As Built Desc: No sidewalk provided
Solution: Construct new firm and stable pedestrian route
Bar. Severity: 1 Necessary Cost Estimate: $17,000.00 Status:
Implementation Priority: 4 Facility Function:
Implementation Phase: Implementation Date:
Official Responsible:
Notes:

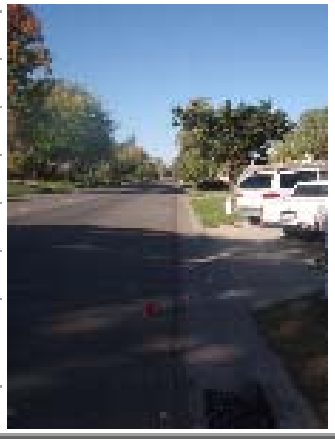
Field Date: 11/1/2010 Report Date: 11/1/2010 Barrier #: 1824

Location: Calvin Dr - North
X Coordinate: -121.30025
Y Coordinate: 38.6989
Barrier Area: Sidewalks
Barrier Type: No sidewalk
Code Ref: CBC 1133B.7.1.3 and ADA/ABA 403.3
As Built Meas: 1252 Quantity: LF
Description: No pedestrian route provided
As Built Desc: No sidewalk provided
Solution: Construct new firm and stable pedestrian route
Bar. Severity: 1 Necessary Cost Estimate: $125,200.00 Status:
Implementation Priority: 4 Facility Function:
Implementation Phase: Implementation Date:
Official Responsible:
Notes:

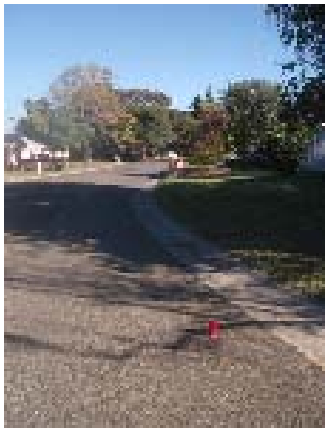
Field Date: 11/1/2010 Report Date: 11/1/2010 Barrier #: 1827
Location: Dolan Wy - East
X Coordinate: -121.30466
Y Coordinate: 38.69885
Barrier Area: Sidewalks
Barrier Type: No sidewalk
Code Ref: CBC 1133B.7.1.3 and ADA/ABA 403.3
As Built Meas: 290 Quantity: LF
Description: No pedestrian route provided
As Built Desc: No sidewalk provided
Solution: Construct new firm and stable pedestrian route
Bar. Severity: 1 Necessary Cost Estimate: $29,000.00 Status:
Implementation Priority: 4 Facility Function:
Implementation Phase: Implementation Date:
Official Responsible:
Notes:

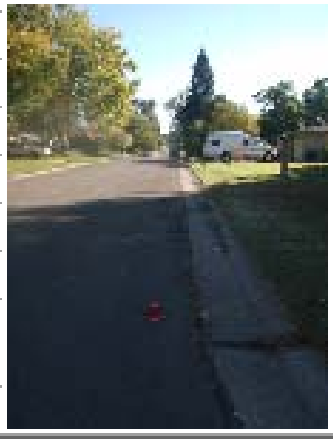
Field Date: 11/1/2010 Report Date: 11/1/2010 Barrier #: 1828

Location: Dolan Wy - South
X Coordinate: -121.30417
Y Coordinate: 38.69968
Barrier Area: Sidewalks
Barrier Type: No sidewalk
Code Ref: CBC 1133B.7.1.3 and ADA/ABA 403.3
As Built Meas: 1147 Quantity: LF
Description: No pedestrian route provided
As Built Desc: No sidewalk provided
Solution: Construct new firm and stable pedestrian route
Bar. Severity: 1 Necessary Cost Estimate: $114,700.00 Status:
Implementation Priority: 4 Facility Function:
Implementation Phase: Implementation Date:
Official Responsible:
Notes:

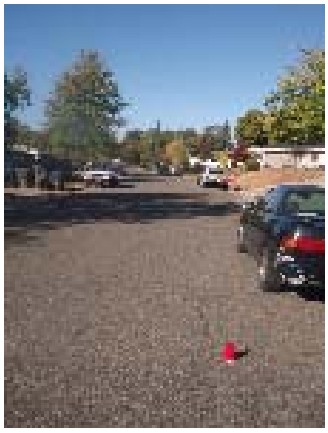
Field Date: 11/1/2010 Report Date: 11/1/2010 Barrier #: 1829

Location: Dolan Wy - North
X Coordinate: -121.30031
Y Coordinate: 38.69969
Barrier Area: Sidewalks
Barrier Type: No sidewalk
Code Ref: CBC 1133B.7.1.3 and ADA/ABA 403.3
As Built Meas: 872 Quantity: LF
Description: No pedestrian route provided
As Built Desc: No sidewalk provided
Solution: Construct new firm and stable pedestrian route
Bar. Severity: 1 Necessary Cost Estimate: $87,200.00 Status:
Implementation Priority: 4 Facility Function:
Implementation Phase: Implementation Date:
Official Responsible:
Notes:

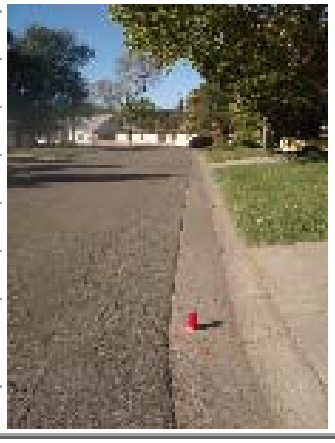
Location: Dolan Wy - North
X Coordinate: -121.30347
Y Coordinate: 38.69976
Barrier Area: Sidewalks
Barrier Type: No sidewalk
Code Ref: CBC 1133B.7.1.3 and ADA/ABA 403.3
As Built Meas: 241 Quantity: LF
Description: No pedestrian route provided
As Built Desc: No sidewalk provided
Solution: Construct new firm and stable pedestrian route
Bar. Severity: 1 Necessary Cost Estimate: $24,100.00 Status:
Implementation Priority: 4 Facility Function:
Implementation Phase: Implementation Date:
Official Responsible:
Notes:

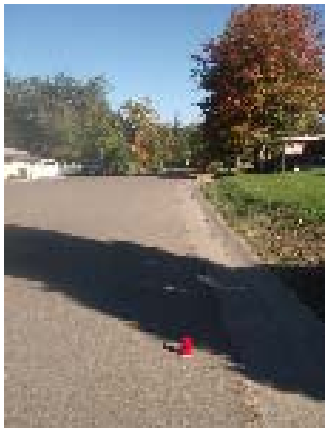
Field Date: 11/1/2010 Report Date: 11/1/2010 Barrier #: 1837
Location: Enright Dr - East
X Coordinate: -121.30568
Y Coordinate: 38.699
Barrier Area: Sidewalks
Barrier Type: No sidewalk
Code Ref: CBC 1133B.7.1.3 and ADA/ABA 403.3
As Built Meas: 481 Quantity: LF
Description: No pedestrian route provided
As Built Desc: No sidewalk provided
Solution: Construct new firm and stable pedestrian route
Bar. Severity: 1 Necessary Cost Estimate: $48,100.00 Status:
Implementation Priority: 4 Facility Function:
Implementation Phase: Implementation Date:
Official Responsible:
Notes:

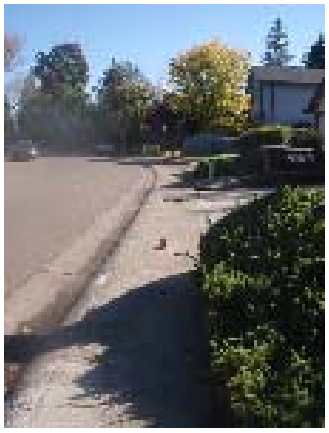
Location: Enright Dr - South
X Coordinate: -121.30443
Y Coordinate: 38.70044
Barrier Area: Sidewalks
Barrier Type: Cross Slope - Existing (5.0% or more)
Code Ref: CBC 1133B.7.1 and ADA/ABA 303.3
As Built Meas: 317 Quantity: LF
Description: Cross slope exceeds 2.0% (5.0% or more)
As Built Desc: 5.0% cross slope
Solution: Demolish existing and construct new route
Bar. Severity: 1 Necessary Cost Estimate: $39,625.00 Status:
Implementation Priority: 4 Facility Function:
Implementation Phase: Implementation Date:
Official Responsible:
Notes:

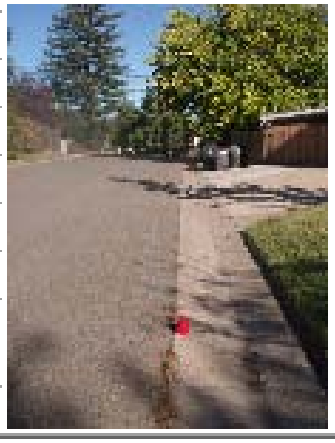
Field Date: 11/1/2010 Report Date: 11/1/2010 Barrier #: 1844

Location: Knudsen Wy - East
X Coordinate: -121.30331
Y Coordinate: 38.69979
Barrier Area: Sidewalks
Barrier Type: No sidewalk
Code Ref: CBC 1133B.7.1.3 and ADA/ABA 403.3
As Built Meas: 99 Quantity: LF
Description: No pedestrian route provided
As Built Desc: No sidewalk provided
Solution: Construct new firm and stable pedestrian route
Bar. Severity: 1 Necessary Cost Estimate: $9,900.00 Status:
Implementation Priority: 4 Facility Function:
Implementation Phase: Implementation Date:
Official Responsible:
Notes:

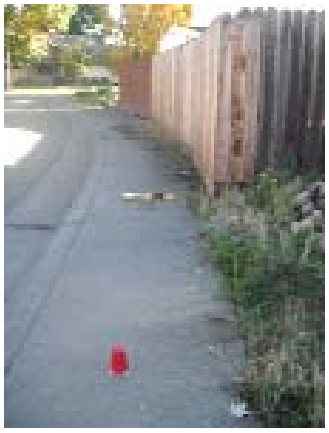
Field Date: 11/1/2010 Report Date: 11/1/2010 Barrier #: 1848
Location: Lovato Ct and Enright Dr - Corner D
X Coordinate: -121.30241
Y Coordinate: 38.70079
Barrier Area: Curb Ramps
Barrier Type: No Curb Ramp - Depressed Existing Curb
Code Ref: CBC 1127B.5.3 and ADA/ABA 406.2
As Built Meas: 1 Quantity: EACH
Description: No compliant curb cut at corner (intersection)
As Built Desc: 12.1% running slope at depressed area
Solution: Demolish existing and construct curb cut
Bar. Severity: 1 Necessary Cost Estimate: $2,500.00 Status:
Implementation Priority: 4 Facility Function:
Implementation Phase: Implementation Date:
Official Responsible:
Notes: Two - way intersection corners C,D

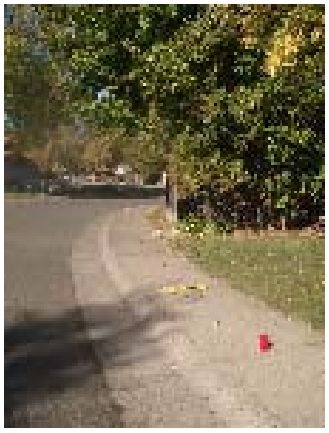
Location: Bogue Wy - North
X Coordinate: -121.30121
Y Coordinate: 38.70056
Barrier Area: Sidewalks
Barrier Type: Cross Slope - Existing (4.1% to 4.9%)
Code Ref: CBC 1133B.7.1.3 and ADA/ABA 403.3
As Built Meas: 192 Quantity: LF
Description: Cross slope exceeds 2.0% (4.1% to 4.9%)
As Built Desc: 4.5% cross slope
Solution: Demolish existing and construct new route
Bar. Severity: 2 Recommended Cost Estimate: $24,000.00 Status:
Implementation Priority: 4 Facility Function:
Implementation Phase: Implementation Date:
Official Responsible:
Notes:

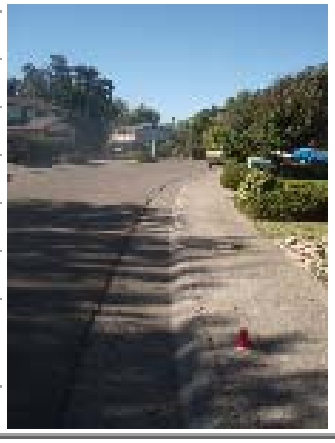
Field Date: 11/1/2010 Report Date: 11/1/2010 Barrier #: 1856

Location: Enright Dr - North
X Coordinate: -121.30347
Y Coordinate: 38.70116
Barrier Area: Sidewalks
Barrier Type: Cross Slope - Existing (5.0% or more)
Code Ref: CBC 1133B.7.1 and ADA/ABA 303.3
As Built Meas: 187 Quantity: LF
Description: Cross slope exceeds 2.0% (5.0% or more)
As Built Desc: 5.8% cross slope
Solution: Demolish existing and construct new route
Bar. Severity: 1 Necessary Cost Estimate: $23,375.00 Status:
Implementation Priority: 4 Facility Function:
Implementation Phase: Implementation Date:
Official Responsible:
Notes:

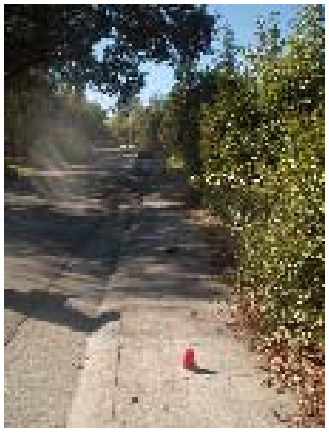
Field Date: 11/1/2010 Report Date: 11/1/2010 Barrier #: 1857

Location: Enright Dr - West
X Coordinate: -121.30484
Y Coordinate: 38.7004
Barrier Area: Sidewalks
Barrier Type: Cross Slope - Existing (5.0% or more)
Code Ref: CBC 1133B.7.1 and ADA/ABA 303.3
As Built Meas: 118 Quantity: LF
Description: Cross slope exceeds 2.0% (5.0% or more)
As Built Desc: 5.8% cross slope
Solution: Demolish existing and construct new route
Bar. Severity: 1 Necessary Cost Estimate: $14,750.00 Status:
Implementation Priority: 4 Facility Function:
Implementation Phase: Implementation Date:
Official Responsible:
Notes:

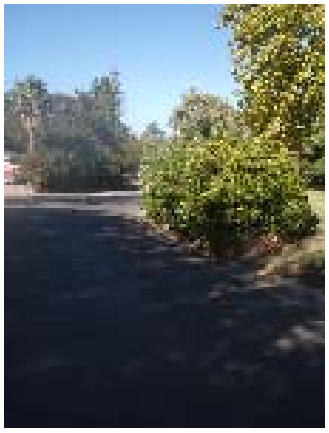
Location: Calvin Dr - North
X Coordinate: -121.30613
Y Coordinate: 38.69897
Barrier Area: Sidewalks
Barrier Type: No sidewalk
Code Ref: CBC 1133B.7.1.3 and ADA/ABA 403.3
As Built Meas: 429 Quantity: LF
Description: No pedestrian route provided
As Built Desc: No sidewalk provided
Solution: Construct new firm and stable pedestrian route
Bar. Severity: 1 Necessary Cost Estimate: $42,900.00 Status:
Implementation Priority: 4 Facility Function:
Implementation Phase: Implementation Date:
Official Responsible:
Notes:

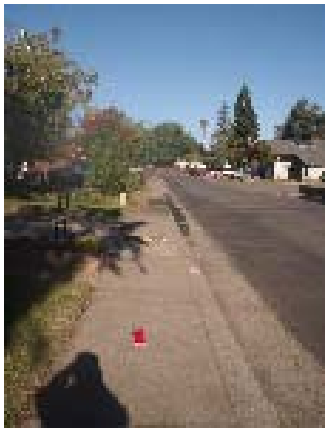
Location: Garden Gate Dr - South
X Coordinate: -121.30651
Y Coordinate: 38.70178
Barrier Area: Sidewalks
Barrier Type: Cross Slope - Existing (4.1% to 4.9%)
Code Ref: CBC 1133B.7.1.3 and ADA/ABA 403.3
As Built Meas: 188 Quantity: LF
Description: Cross slope exceeds 2.0% (4.1% to 4.9%)
As Built Desc: 4.5% cross slope
Solution: Demolish existing and construct new route
Bar. Severity: 2 Recommended Cost Estimate: $23,500.00 Status:
Implementation Priority: 4 Facility Function:
Implementation Phase: Implementation Date:
Official Responsible:
Notes:

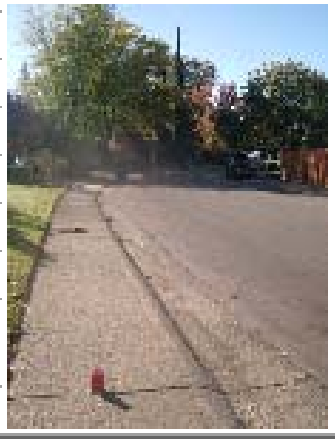
Field Date: 11/2/2010 Report Date: 11/2/2010 Barrier #: 1870

Location: Hollyhock Ct - East
X Coordinate: -121.30715
Y Coordinate: 38.70071
Barrier Area: Sidewalks
Barrier Type: Cross Slope - Existing (5.0% or more)
Code Ref: CBC 1133B.7.1 and ADA/ABA 303.3
As Built Meas: 433 Quantity: LF
Description: Cross slope exceeds 2.0% (5.0% or more)
As Built Desc: 5.8% cross slope
Solution: Demolish existing and construct new route
Bar. Severity: 1 Necessary Cost Estimate: $54,125.00 Status:
Implementation Priority: 4 Facility Function:
Implementation Phase: Implementation Date:
Official Responsible:
Notes:

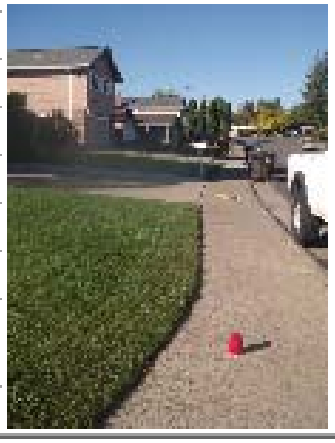
Field Date: 11/2/2010 Report Date: 11/2/2010 Barrier #: 1872

Location: Garden Gate Dr - South
X Coordinate: -121.30737
Y Coordinate: 38.70151
Barrier Area: Sidewalks
Barrier Type: Cross Slope - Existing (5.0% or more)
Code Ref: CBC 1133B.7.1 and ADA/ABA 303.3
As Built Meas: 311 Quantity: LF
Description: Cross slope exceeds 2.0% (5.0% or more)
As Built Desc: 5.1% cross slope
Solution: Demolish existing and construct new route
Bar. Severity: 1 Necessary Cost Estimate: $38,875.00 Status:
Implementation Priority: 4 Facility Function:
Implementation Phase: Implementation Date:
Official Responsible:
Notes:

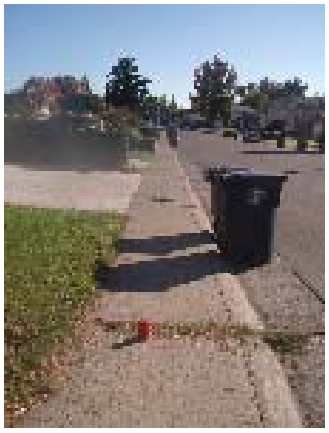
Field Date: 11/2/2010 Report Date: 11/2/2010 Barrier #: 1874
Location: Garden Gate Dr and Van Maren Ln - Corner C
X Coordinate: -121.30872
Y Coordinate: 38.7015
Barrier Area: Curb Ramps
Barrier Type: No Curb Ramp - Depressed Existing Curb
Code Ref: CBC 1127B.5.3 and ADA/ABA 406.2
As Built Meas: 1 Quantity: EACH
Description: No compliant curb cut at corner (intersection)
As Built Desc: 10.9% running slope at depressed area
Solution: Demolish existing and construct curb cut
Bar. Severity: 1 Necessary Cost Estimate: $2,500.00 Status:
Implementation Priority: 4 Facility Function:
Implementation Phase: Implementation Date:
Official Responsible:
Notes: Two - way intersection corners B,C

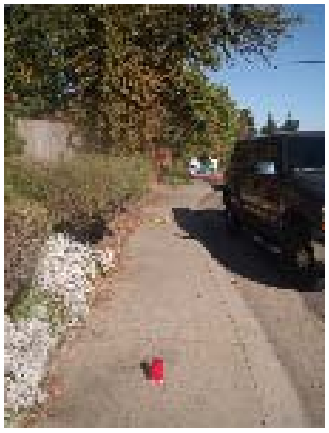
Field Date: 11/2/2010 Report Date: 11/2/2010 Barrier #: 1880
Location: Garden Gate Dr and Marinvale Dr - Corner D
X Coordinate: -121.30589
Y Coordinate: 38.70343
Barrier Area: Curb Ramps
Barrier Type: No Curb Ramp
Code Ref: CBC 1127B.5.3 and ADA/ABA 406.2
As Built Meas: 1 Quantity: EACH
Description: No curb cut at corner (intersection)
As Built Desc: No curb ramp at corner
Solution: Demolish existing and construct curb cut
Bar. Severity: 1 Necessary Cost Estimate: $2,500.00 Status:
Implementation Priority: 4 Facility Function:
Implementation Phase: Implementation Date:
Official Responsible:
Notes: Two - way intersection corners A,D
