CITY OF CITRUS HEIGHTS

DRAFT ADA TRANSITION PLAN UPDATE

NEIGHBORHOOD AREA 2 RUSCH PARK

SEPTEMBER 20, 2011

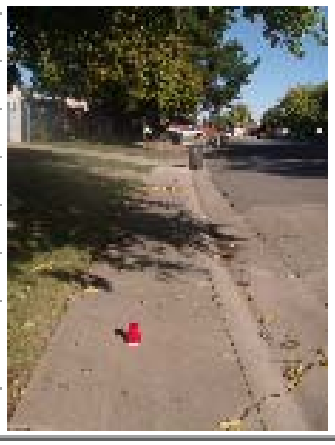
Field Date: 11/2/2010 Report Date: 11/2/2010 Barrier #: 1886

Location: Garden Gate Dr - West
X Coordinate: -121.30596
Y Coordinate: 38.70529
Barrier Area: Sidewalks
Barrier Type: Cross Slope - Existing (5.0% or more)
Code Ref: CBC 1133B.7.1 and ADA/ABA 303.3
As Built Meas: 374 Quantity: LF
Description: Cross slope exceeds 2.0% (5.0% or more)
As Built Desc: 5.0% cross slope
Solution: Demolish existing and construct new route
Bar. Severity: 1 Necessary Cost Estimate: $46,750.00 Status:
Implementation Priority: 4 Facility Function:
Implementation Phase: Implementation Date:
Official Responsible:
Notes:

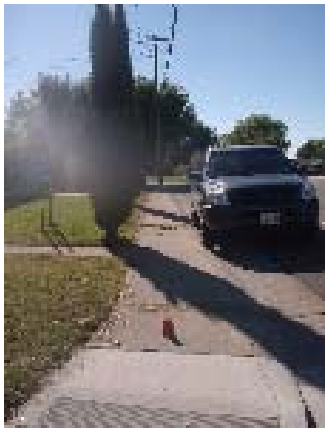
Field Date: 11/2/2010 Report Date: 11/2/2010 Barrier #: 1903A

Location: Van Maren Ln - East
X Coordinate: -121.30869
Y Coordinate: 38.70481
Barrier Area: Sidewalks
Barrier Type: Cross Slope - Existing (5.0% or more)
Code Ref: CBC 1133B.7.1 and ADA/ABA 303.3
As Built Meas: 159 Quantity: LF
Description: Cross slope exceeds 2.0% (5.0% or more)
As Built Desc: 5.1% cross slope
Solution: Demolish existing and construct new route
Bar. Severity: 1 Necessary Cost Estimate: $19,875.00 Status:
Implementation Priority: 1 Facility Function:
Implementation Phase: Implementation Date:
Official Responsible:
Notes:

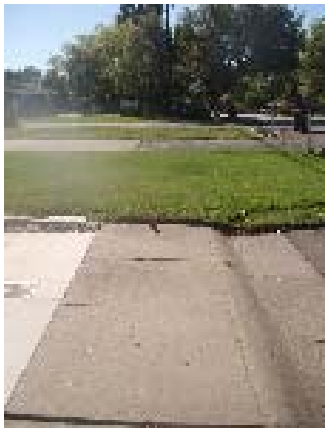
Field Date: 11/2/2010 Report Date: 11/2/2010 Barrier #: 1903C
Location: Van Maren Ln - East
X Coordinate: -121.3087
Y Coordinate: 38.70453
Barrier Area: Sidewalks
Barrier Type: No Sidewalk - No Barricade
Code Ref: CBC 1133B.7.1.3 and ADA/ABA 403.3
As Built Meas: 1 Quantity: JOB
Description: No barricade provided where sidewalk ends in hazardous location
As Built Desc: No barricade or other warning provided for the visually impaired at end of sidewalk
Solution: Provide barricade with cane detectable warning at end of sidewalk
Bar. Severity: 1 Necessary Cost Estimate: $1,350.00 Status:
Implementation Priority: 1 Facility Function:
Implementation Phase: Implementation Date:
Official Responsible:
Notes:

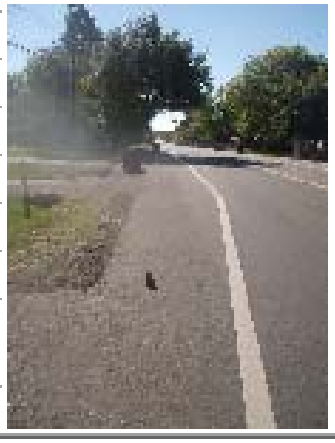
Location: Van Maren Ln - East
X Coordinate: -121.30871
Y Coordinate: 38.70423
Barrier Area: Sidewalks
Barrier Type: Shoulder Cross Slope - Existing (3.1% to 4.0%)
Code Ref: CBC 1133B.7.1.3 and ADA/ABA 403.3
As Built Meas: 450 Quantity: LF
Description: Cross slope exceeds 2.0% (3.1% to 4.0%)
As Built Desc: 3.8% cross slope
Solution: Demolish existing and construct new pedestrian route
Bar. Severity: 3 Hinderance Cost Estimate: $56,250.00 Status:
Implementation Priority: 1 Facility Function:
Implementation Phase: Implementation Date:
Official Responsible:
Notes:

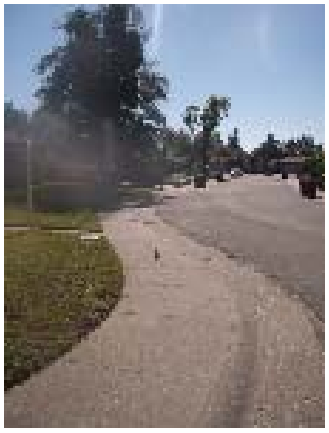
Field Date: 11/2/2010 Report Date: 11/2/2010 Barrier #: 1911
Location: Easthaven Wy - East
X Coordinate: -121.30766
Y Coordinate: 38.70305
Barrier Area: Sidewalks
Barrier Type: Cross Slope - Existing (4.1% to 4.9%)
Code Ref: CBC 1133B.7.1.3 and ADA/ABA 403.3
As Built Meas: 269 Quantity: LF
Description: Cross slope exceeds 2.0% (4.1% to 4.9%)
As Built Desc: 4.8% cross slope
Solution: Demolish existing and construct new route
Bar. Severity: 2 Recommended Cost Estimate: $33,625.00 Status:
Implementation Priority: 4 Facility Function:
Implementation Phase: Implementation Date:
Official Responsible:
Notes:

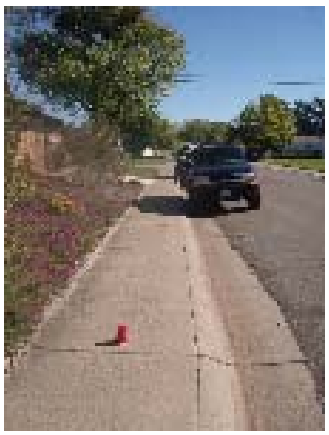
Location: Easthaven Wy - North
X Coordinate: -121.3073
Y Coordinate: 38.7023
Barrier Area: Sidewalks
Barrier Type: Cross Slope - Existing (5.0% or more)
Code Ref: CBC 1133B.7.1 and ADA/ABA 303.3
As Built Meas: 188 Quantity: LF
Description: Cross slope exceeds 2.0% (5.0% or more)
As Built Desc: 5.0% cross slope
Solution: Demolish existing and construct new route
Bar. Severity: 1 Necessary Cost Estimate: $23,500.00 Status:
Implementation Priority: 4 Facility Function:
Implementation Phase: Implementation Date:
Official Responsible:
Notes:

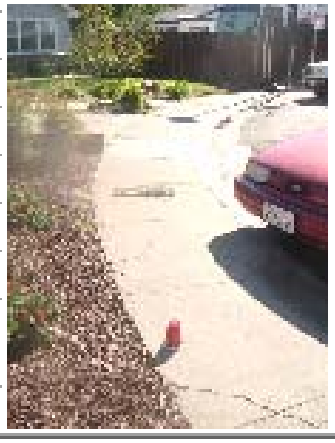
Field Date: 11/2/2010 Report Date: 11/2/2010 Barrier #: 1916

Location: Lake Hurst Ct - East
X Coordinate: -121.30661
Y Coordinate: 38.70253
Barrier Area: Sidewalks
Barrier Type: Cross Slope - Existing (5.0% or more)
Code Ref: CBC 1133B.7.1 and ADA/ABA 303.3
As Built Meas: 169 Quantity: LF
Description: Cross slope exceeds 2.0% (5.0% or more)
As Built Desc: 5.2% cross slope
Solution: Demolish existing and construct new route
Bar. Severity: 1 Necessary Cost Estimate: $21,125.00 Status:
Implementation Priority: 4 Facility Function:
Implementation Phase: Implementation Date:
Official Responsible:
Notes:

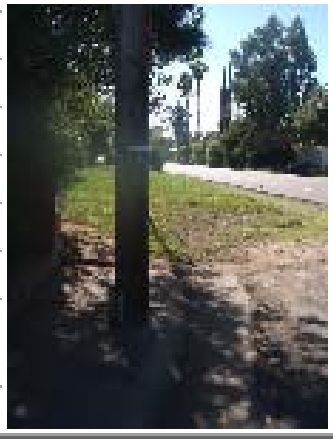
Location: Van Maren Ln - East
X Coordinate: -121.30872
Y Coordinate: 38.7031
Barrier Area: Sidewalks
Barrier Type: No sidewalk (end of path)
Code Ref: CBC 1133B.8.5
As Built Meas: 1 Quantity: JOB
Description: Sidewalk route ends and no opposite sidewalk exists
As Built Desc: Directional sign lacking forcing pedestrians to retrace their steps
Solution: Provide directional sign at junction in route to allow travel in shoulder
Bar. Severity: 1 Necessary Cost Estimate: $100.00 Status:
Implementation Priority: 1 Facility Function:
Implementation Phase: Implementation Date:
Official Responsible:
Notes:

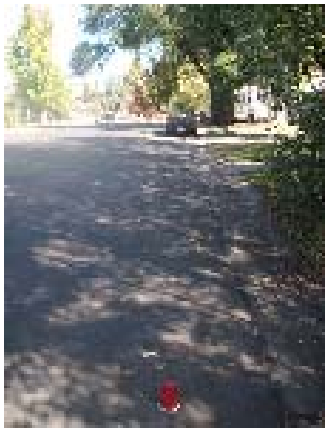
Field Date: 11/2/2010 Report Date: 11/2/2010 Barrier #: 1935

Location: Henning Dr - East
X Coordinate: -121.30672
Y Coordinate: 38.6999
Barrier Area: Sidewalks
Barrier Type: No sidewalk
Code Ref: CBC 1133B.7.1.3 and ADA/ABA 403.3
As Built Meas: 177 Quantity: LF
Description: No pedestrian route provided
As Built Desc: No sidewalk provided
Solution: Construct new firm and stable pedestrian route
Bar. Severity: 1 Necessary Cost Estimate: $17,700.00 Status:
Implementation Priority: 4 Facility Function:
Implementation Phase: Implementation Date:
Official Responsible:
Notes:

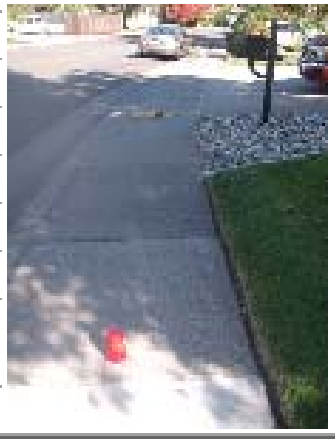
Field Date: 11/2/2010 Report Date: 11/2/2010 Barrier #: 1936

Location: Henning Dr - East
X Coordinate: -121.30619
Y Coordinate: 38.70038
Barrier Area: Sidewalks
Barrier Type: Cross Slope - Existing (5.0% or more)
Code Ref: CBC 1133B.7.1 and ADA/ABA 303.3
As Built Meas: 737 Quantity: LF
Description: Cross slope exceeds 2.0% (5.0% or more)
As Built Desc: 5.2% cross slope
Solution: Demolish existing and construct new route
Bar. Severity: 1 Necessary Cost Estimate: $92,125.00 Status:
Implementation Priority: 4 Facility Function:
Implementation Phase: Implementation Date:
Official Responsible:
Notes:

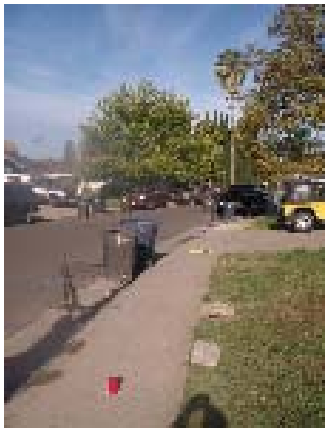
Field Date: 11/3/2010 Report Date: 11/3/2010 Barrier #: 1953

Location: Circlet Wy - East
X Coordinate: -121.30495
Y Coordinate: 38.69733
Barrier Area: Sidewalks
Barrier Type: Cross Slope - Existing (5.0% or more)
Code Ref: CBC 1133B.7.1 and ADA/ABA 303.3
As Built Meas: 261 Quantity: LF
Description: Cross slope exceeds 2.0% (5.0% or more)
As Built Desc: 5.1% cross slope
Solution: Demolish existing and construct new route
Bar. Severity: 1 Necessary Cost Estimate: $32,625.00 Status:
Implementation Priority: 4 Facility Function:
Implementation Phase: Implementation Date:
Official Responsible:
Notes:

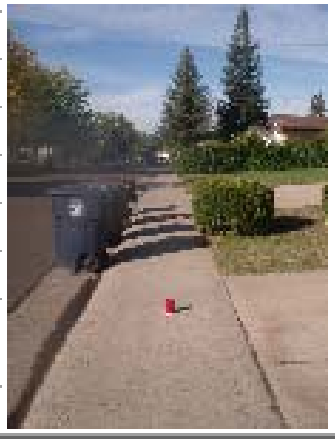
Field Date: 11/3/2010 Report Date: 11/3/2010 Barrier #: 1954

Location: Circlet Wy - North
X Coordinate: -121.30543
Y Coordinate: 38.69804
Barrier Area: Sidewalks
Barrier Type: Cross Slope - Existing (5.0% or more)
Code Ref: CBC 1133B.7.1 and ADA/ABA 303.3
As Built Meas: 636 Quantity: LF
Description: Cross slope exceeds 2.0% (5.0% or more)
As Built Desc: 5.6% cross slope
Solution: Demolish existing and construct new route
Bar. Severity: 1 Necessary Cost Estimate: $79,500.00 Status:
Implementation Priority: 4 Facility Function:
Implementation Phase: Implementation Date:
Official Responsible:
Notes:

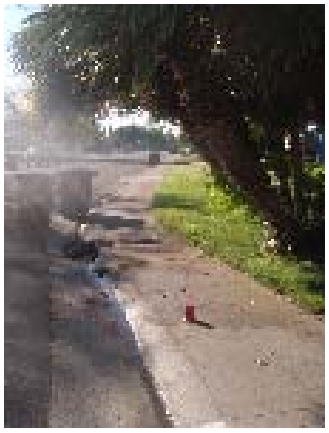
Field Date: 11/3/2010 Report Date: 11/3/2010 Barrier #: 1955

Location: Circlet Wy - West
X Coordinate: -121.30784
Y Coordinate: 38.69788
Barrier Area: Sidewalks
Barrier Type: Cross Slope - Existing (5.0% or more)
Code Ref: CBC 1133B.7.1 and ADA/ABA 303.3
As Built Meas: 340 Quantity: LF
Description: Cross slope exceeds 2.0% (5.0% or more)
As Built Desc: 5.2% cross slope
Solution: Demolish existing and construct new route
Bar. Severity: 1 Necessary Cost Estimate: $42,500.00 Status:
Implementation Priority: 4 Facility Function:
Implementation Phase: Implementation Date:
Official Responsible:
Notes:

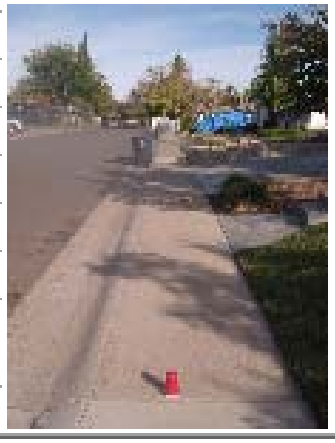
Field Date: 11/3/2010 Report Date: 11/3/2010 Barrier #: 1958

Location: Circlet Wy - East
X Coordinate: -121.30772
Y Coordinate: 38.6967
Barrier Area: Sidewalks
Barrier Type: Cross Slope - Existing (5.0% or more)
Code Ref: CBC 1133B.7.1 and ADA/ABA 303.3
As Built Meas: 240 Quantity: LF
Description: Cross slope exceeds 2.0% (5.0% or more)
As Built Desc: 5.1% cross slope
Solution: Demolish existing and construct new route
Bar. Severity: 1 Necessary Cost Estimate: $30,000.00 Status:
Implementation Priority: 4 Facility Function:
Implementation Phase: Implementation Date:
Official Responsible:
Notes:

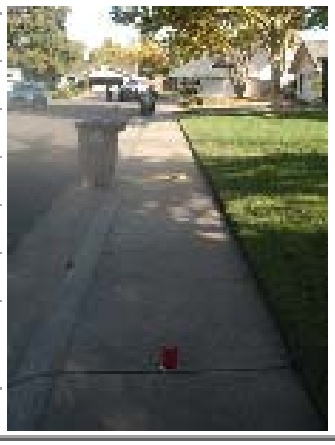
Field Date: 11/3/2010 Report Date: 11/3/2010 Barrier #: 1961

Location: Brougham Wy - East
X Coordinate: -121.30616
Y Coordinate: 38.69683
Barrier Area: Sidewalks
Barrier Type: Cross Slope - Existing (5.0% or more)
Code Ref: CBC 1133B.7.1 and ADA/ABA 303.3
As Built Meas: 136 Quantity: LF
Description: Cross slope exceeds 2.0% (5.0% or more)
As Built Desc: 5.2% cross slope
Solution: Demolish existing and construct new route
Bar. Severity: 1 Necessary Cost Estimate: $17,000.00 Status:
Implementation Priority: 4 Facility Function:
Implementation Phase: Implementation Date:
Official Responsible:
Notes:

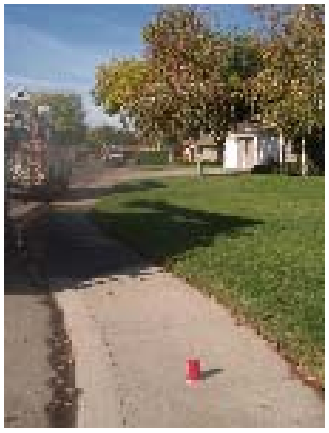
Location: Brougham Wy - North
X Coordinate: -121.30629
Y Coordinate: 38.69735
Barrier Area: Sidewalks
Barrier Type: Cross Slope - Existing (4.1% to 4.9%)
Code Ref: CBC 1133B.7.1.3 and ADA/ABA 403.3
As Built Meas: 398 Quantity: LF
Description: Cross slope exceeds 2.0% (4.1% to 4.9%)
As Built Desc: 4.7% cross slope
Solution: Demolish existing and construct new route
Bar. Severity: 2 Recommended Cost Estimate: $49,750.00 Status:
Implementation Priority: 4 Facility Function:
Implementation Phase: Implementation Date:
Official Responsible:
Notes:

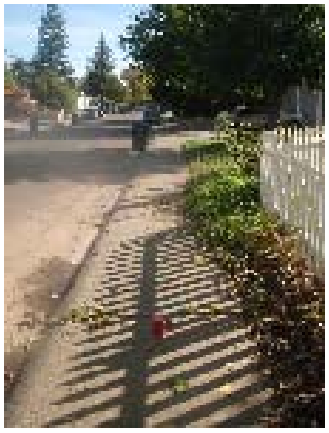
Field Date: 11/3/2010 Report Date: 11/3/2010 Barrier #: 1964

Location: Circlet Wy - South
X Coordinate: -121.30717
Y Coordinate: 38.69794
Barrier Area: Sidewalks
Barrier Type: Cross Slope - Existing (5.0% or more)
Code Ref: CBC 1133B.7.1 and ADA/ABA 303.3
As Built Meas: 466 Quantity: LF
Description: Cross slope exceeds 2.0% (5.0% or more)
As Built Desc: 5.6% cross slope
Solution: Demolish existing and construct new route
Bar. Severity: 1 Necessary Cost Estimate: $58,250.00 Status:
Implementation Priority: 4 Facility Function:
Implementation Phase: Implementation Date:
Official Responsible:
Notes:

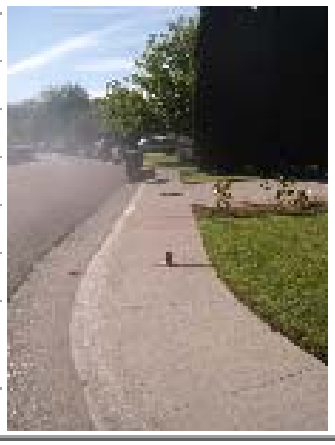
Location: Circlet Wy - West
X Coordinate: -121.30529
Y Coordinate: 38.69787
Barrier Area: Sidewalks
Barrier Type: Cross Slope - Existing (4.1% to 4.9%)
Code Ref: CBC 1133B.7.1.3 and ADA/ABA 403.3
As Built Meas: 151 Quantity: LF
Description: Cross slope exceeds 2.0% (4.1% to 4.9%)
As Built Desc: 4.7% cross slope
Solution: Demolish existing and construct new route
Bar. Severity: 2 Recommended Cost Estimate: $18,875.00 Status:
Implementation Priority: 4 Facility Function:
Implementation Phase: Implementation Date:
Official Responsible:
Notes:

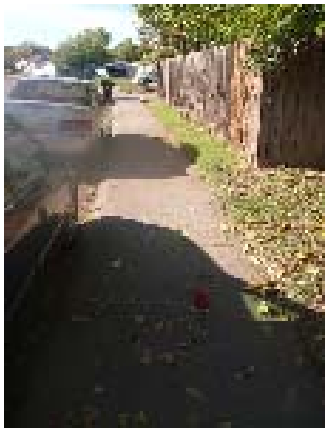
Location: Cobalt Wy - North
X Coordinate: -121.3051
Y Coordinate: 38.69716
Barrier Area: Sidewalks
Barrier Type: Cross Slope - Existing (4.1% to 4.9%)
Code Ref: CBC 1133B.7.1.3 and ADA/ABA 403.3
As Built Meas: 260 Quantity: LF
Description: Cross slope exceeds 2.0% (4.1% to 4.9%)
As Built Desc: 4.1% cross slope
Solution: Demolish existing and construct new route
Bar. Severity: 2 Recommended Cost Estimate: $32,500.00 Status:
Implementation Priority: 4 Facility Function:
Implementation Phase: Implementation Date:
Official Responsible:
Notes:

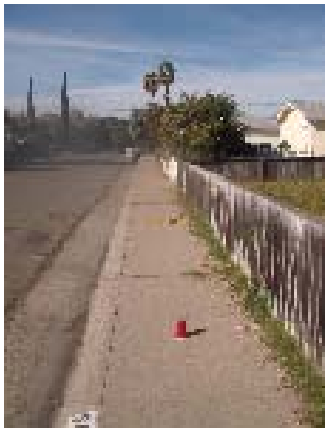
Field Date: 11/3/2010 Report Date: 11/3/2010 Barrier #: 1969
Location: Candelabra Dr - North
X Coordinate: -121.30674
Y Coordinate: 38.69663
Barrier Area: Sidewalks
Barrier Type: Cross Slope - Existing (5.0% or more)
Code Ref: CBC 1133B.7.1 and ADA/ABA 303.3
As Built Meas: 223 Quantity: LF
Description: Cross slope exceeds 2.0% (5.0% or more)
As Built Desc: 5.1% cross slope
Solution: Demolish existing and construct new route
Bar. Severity: 1 Necessary Cost Estimate: $27,875.00 Status:
Implementation Priority: 4 Facility Function:
Implementation Phase: Implementation Date:
Official Responsible:
Notes:

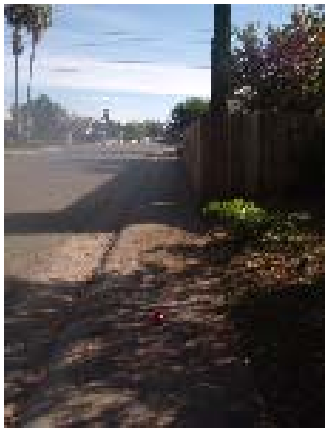
Field Date: 11/3/2010 Report Date: 11/3/2010 Barrier #: 1972
Location: Candelabra Dr and Van Maren Ln - Corner C
X Coordinate: -121.30863
Y Coordinate: 38.69652
Barrier Area: Curb Ramps
Barrier Type: No Curb Ramp
Code Ref: CBC 1127B.5.3 and ADA/ABA 406.2
As Built Meas: 1 Quantity: EACH
Description: No curb cut at corner (intersection)
As Built Desc: No curb ramp at corner
Solution: Demolish existing and construct curb cut
Bar. Severity: 1 Necessary Cost Estimate: $2,500.00 Status:
Implementation Priority: 4 Facility Function:
Implementation Phase: Implementation Date:
Official Responsible:
Notes: Two - way intersection corners B,C

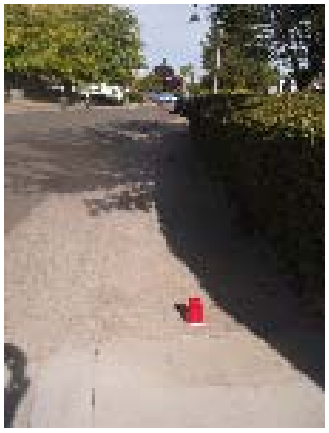
Field Date: 11/3/2010 Report Date: 11/3/2010 Barrier #: 1975A

Location: Circlet Wy - East
X Coordinate: -121.30776
Y Coordinate: 38.69461
Barrier Area: Sidewalks
Barrier Type: Cross Slope - Existing (4.1% to 4.9%)
Code Ref: CBC 1133B.7.1.3 and ADA/ABA 403.3
As Built Meas: 212 Quantity: LF
Description: Cross slope exceeds 2.0% (4.1% to 4.9%)
As Built Desc: 4.9% cross slope
Solution: Demolish existing and construct new route
Bar. Severity: 2 Recommended Cost Estimate: $26,500.00 Status:
Implementation Priority: 4 Facility Function:
Implementation Phase: Implementation Date:
Official Responsible:
Notes:

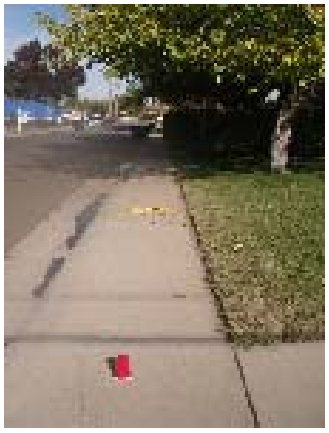
Field Date: 11/3/2010 Report Date: 11/3/2010 Barrier #: 1976A

Location: Circlet Wy - East
X Coordinate: -121.30775
Y Coordinate: 38.69528
Barrier Area: Sidewalks
Barrier Type: Cross Slope - Existing (5.0% or more)
Code Ref: CBC 1133B.7.1 and ADA/ABA 303.3
As Built Meas: 401 Quantity: LF
Description: Cross slope exceeds 2.0% (5.0% or more)
As Built Desc: 5.1% cross slope
Solution: Demolish existing and construct new route
Bar. Severity: 1 Necessary Cost Estimate: $50,125.00 Status:
Implementation Priority: 4 Facility Function:
Implementation Phase: Implementation Date:
Official Responsible:
Notes:

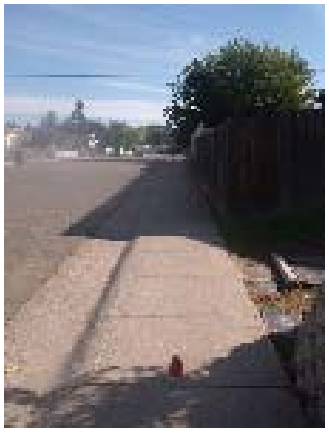
Field Date: 11/3/2010 Report Date: 11/3/2010 Barrier #: 1976B
Location: Circlet Wy - East
X Coordinate: -121.30777
Y Coordinate: 38.69537
Barrier Area: Sidewalks
Barrier Type: Abrupt Change in Level - > 1/2"
Code Ref: CBC 1133B.7.1 and ADA/ABA 303.3
As Built Meas: 4 Quantity: LF
Description: Change in level greater than 1/2"
As Built Desc: 1/2" lip in sidewalk surface
Solution: Grind or repair sidewalk to remove trip hazard
Bar. Severity: 1 Necessary Cost Estimate: $1,000.00 Status:
Implementation Priority: 4 Facility Function:
Implementation Phase: Implementation Date:
Official Responsible:
Notes:

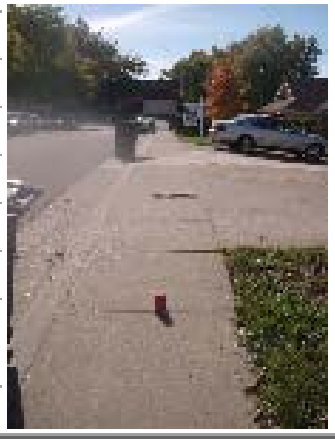
Location: Ansley Ct - West
X Coordinate: -121.30698
Y Coordinate: 38.69627
Barrier Area: Sidewalks
Barrier Type: Cross Slope - Existing (5.0% or more)
Code Ref: CBC 1133B.7.1 and ADA/ABA 303.3
As Built Meas: 252 Quantity: LF
Description: Cross slope exceeds 2.0% (5.0% or more)
As Built Desc: 5.1% cross slope
Solution: Demolish existing and construct new route
Bar. Severity: 1 Necessary Cost Estimate: $31,500.00 Status:
Implementation Priority: 4 Facility Function:
Implementation Phase: Implementation Date:
Official Responsible:
Notes:

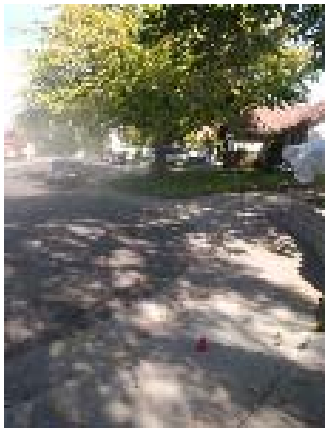
Field Date: 11/3/2010 Report Date: 11/3/2010 Barrier #: 1979A

Location: Ansley Ct - East
X Coordinate: -121.30673
Y Coordinate: 38.69555
Barrier Area: Sidewalks
Barrier Type: Cross Slope - Existing (5.0% or more)
Code Ref: CBC 1133B.7.1 and ADA/ABA 303.3
As Built Meas: 393 Quantity: LF
Description: Cross slope exceeds 2.0% (5.0% or more)
As Built Desc: 5.1% cross slope
Solution: Demolish existing and construct new route
Bar. Severity: 1 Necessary Cost Estimate: $49,125.00 Status:
Implementation Priority: 4 Facility Function:
Implementation Phase: Implementation Date:
Official Responsible:
Notes:

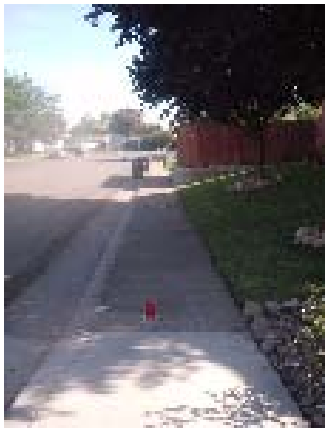
Field Date: 11/3/2010 Report Date: 11/3/2010 Barrier #: 1979B
Location: Ansley Ct - East
X Coordinate: -121.30682
Y Coordinate: 38.69609
Barrier Area: Sidewalks
Barrier Type: Abrupt Change in Level - > 1/2"
Code Ref: CBC 1133B.7.1 and ADA/ABA 303.3
As Built Meas: 4 Quantity: LF
Description: Change in level greater than 1/2"
As Built Desc: 2" lip in sidewalk surface
Solution: Grind or repair sidewalk to remove trip hazard
Bar. Severity: 1 Necessary Cost Estimate: $1,000.00 Status:
Implementation Priority: 4 Facility Function:
Implementation Phase: Implementation Date:
Official Responsible:
Notes:

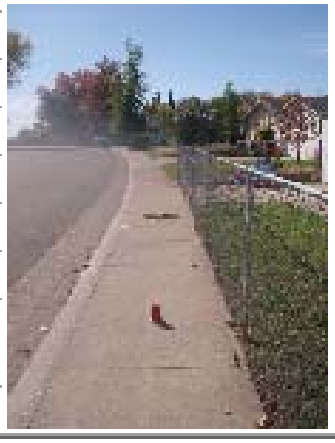
Location: Cobalt Wy - West
X Coordinate: -121.30576
Y Coordinate: 38.69632
Barrier Area: Sidewalks
Barrier Type: Cross Slope - Existing (4.1% to 4.9%)
Code Ref: CBC 1133B.7.1.3 and ADA/ABA 403.3
As Built Meas: 523 Quantity: LF
Description: Cross slope exceeds 2.0% (4.1% to 4.9%)
As Built Desc: 4.9% cross slope
Solution: Demolish existing and construct new route
Bar. Severity: 2 Recommended Cost Estimate: $65,375.00 Status:
Implementation Priority: 4 Facility Function:
Implementation Phase: Implementation Date:
Official Responsible:
Notes:

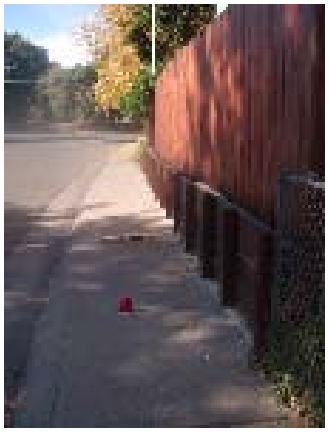
Field Date: 11/3/2010 Report Date: 11/3/2010 Barrier #: 1988

Location: Winlock Ave - North
X Coordinate: -121.3079
Y Coordinate: 38.69438
Barrier Area: Sidewalks
Barrier Type: Cross Slope - Existing (4.1% to 4.9%)
Code Ref: CBC 1133B.7.1.3 and ADA/ABA 403.3
As Built Meas: 119 Quantity: LF
Description: Cross slope exceeds 2.0% (4.1% to 4.9%)
As Built Desc: 4.9% cross slope
Solution: Demolish existing and construct new route
Bar. Severity: 2 Recommended Cost Estimate: $14,875.00 Status:
Implementation Priority: 4 Facility Function:
Implementation Phase: Implementation Date:
Official Responsible:
Notes:

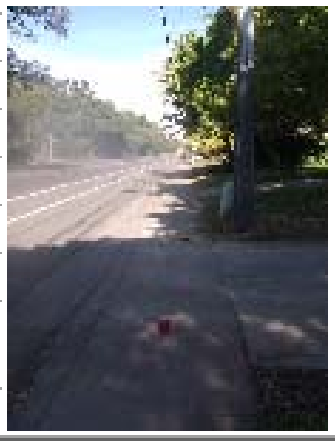
Location: Van Maren Ln - East
X Coordinate: -121.30866
Y Coordinate: 38.69564
Barrier Area: Sidewalks
Barrier Type: Cross Slope - Existing (4.1% to 4.9%)
Code Ref: CBC 1133B.7.1.3 and ADA/ABA 403.3
As Built Meas: 277 Quantity: LF
Description: Cross slope exceeds 2.0% (4.1% to 4.9%)
As Built Desc: 4.9% cross slope
Solution: Demolish existing and construct new route
Bar. Severity: 2 Recommended Cost Estimate: $34,625.00 Status:
Implementation Priority: 1 Facility Function:
Implementation Phase: Implementation Date:
Official Responsible:
Notes:

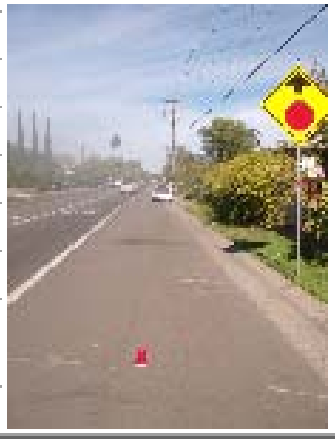
Location: Van Maren Ln - East
X Coordinate: -121.3087
Y Coordinate: 38.69961
Barrier Area: Sidewalks
Barrier Type: Shoulder Cross Slope - Existing (3.1% to 4.0%)
Code Ref: CBC 1133B.7.1.3 and ADA/ABA 403.3
As Built Meas: 1129 Quantity: LF
Description: Cross slope exceeds 2.0% (3.1% to 4.0%)
As Built Desc: 3.5% cross slope
Solution: Demolish existing and construct new pedestrian route
Bar. Severity: 3 Hinderance Cost Estimate: $141,125.00 Status:
Implementation Priority: 1 Facility Function:
Implementation Phase: Implementation Date:
Official Responsible:
Notes:

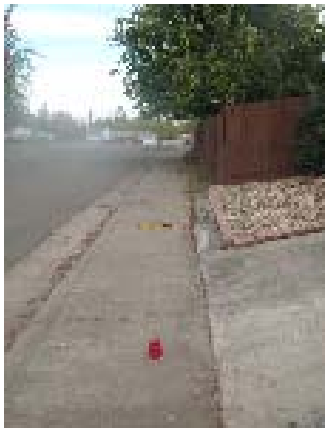
Field Date: 11/4/2010 Report Date: 11/4/2010 Barrier #: 1998C
Location: Winlock Ave and Cobalt Wy - Corner D
X Coordinate: -121.30597
Y Coordinate: 38.69472
Barrier Area: Curb Ramps
Barrier Type: Gutter Slope - Existing (8.3% or more)
Code Ref: CBC 1127B.5.3 and ADA/ABA 406.2
As Built Meas: 6 Quantity: SF
Description: Gutter slope exceeds 5.0% (8.3% or more)
As Built Desc: 9.0% gutter slope
Solution: Demolish existing and construct new gutter
Bar. Severity: 1 Necessary Cost Estimate: $0.00 Status:
Implementation Priority: 4 Facility Function:
Implementation Phase: Implementation Date:
Official Responsible:
Notes: Four - way intersection corners A,B,C,D

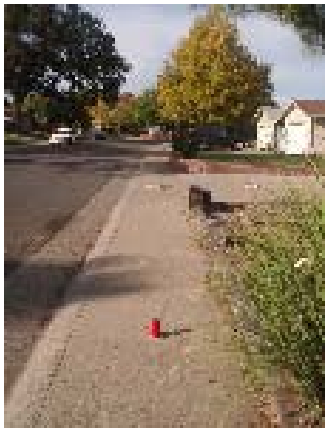
Field Date: 11/4/2010 Report Date: 11/4/2010 Barrier #: 2005

Location: Franela Wy - North
X Coordinate: -121.30278
Y Coordinate: 38.69655
Barrier Area: Sidewalks
Barrier Type: Cross Slope - Existing (3.1% to 4.0%)
Code Ref: CBC 1133B.7.1.3 and ADA/ABA 403.3
As Built Meas: 146 Quantity: LF
Description: Cross slope exceeds 2.0% (3.1% to 4.0%)
As Built Desc: 4.0% cross slope
Solution: Demolish existing and construct new route
Bar. Severity: 3 Hinderance Cost Estimate: $18,250.00 Status:
Implementation Priority: 4 Facility Function:
Implementation Phase: Implementation Date:
Official Responsible:
Notes:

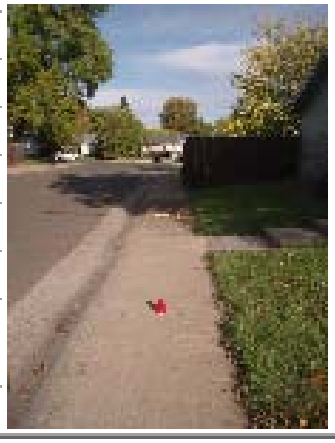
Location: Carana Wy - North
X Coordinate: -121.30348
Y Coordinate: 38.6964
Barrier Area: Sidewalks
Barrier Type: Cross Slope - Existing (4.1% to 4.9%)
Code Ref: CBC 1133B.7.1.3 and ADA/ABA 403.3
As Built Meas: 190 Quantity: LF
Description: Cross slope exceeds 2.0% (4.1% to 4.9%)
As Built Desc: 4.7% cross slope
Solution: Demolish existing and construct new route
Bar. Severity: 2 Recommended Cost Estimate: $23,750.00 Status:
Implementation Priority: 4 Facility Function:
Implementation Phase: Implementation Date:
Official Responsible:
Notes:

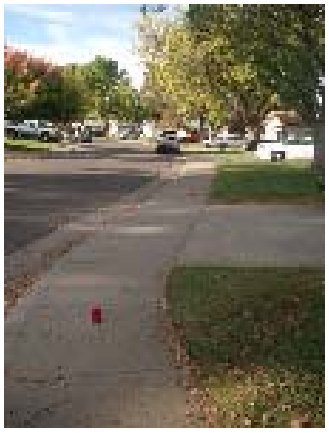
Field Date: 11/4/2010 Report Date: 11/4/2010 Barrier #: 2007

Location: Carana Wy - West
X Coordinate: -121.30394
Y Coordinate: 38.69693
Barrier Area: Sidewalks
Barrier Type: Cross Slope - Existing (5.0% or more)
Code Ref: CBC 1133B.7.1 and ADA/ABA 303.3
As Built Meas: 600 Quantity: LF
Description: Cross slope exceeds 2.0% (5.0% or more)
As Built Desc: 5.9% cross slope
Solution: Demolish existing and construct new route
Bar. Severity: 1 Necessary Cost Estimate: $75,000.00 Status:
Implementation Priority: 4 Facility Function:
Implementation Phase: Implementation Date:
Official Responsible:
Notes:

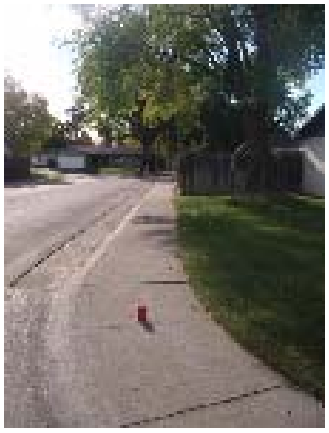
Field Date: 11/4/2010 Report Date: 11/4/2010 Barrier #: 2009

Location: Carana Wy - South
X Coordinate: -121.30382
Y Coordinate: 38.69679
Barrier Area: Sidewalks
Barrier Type: Cross Slope - Existing (5.0% or more)
Code Ref: CBC 1133B.7.1 and ADA/ABA 303.3
As Built Meas: 174 Quantity: LF
Description: Cross slope exceeds 2.0% (5.0% or more)
As Built Desc: 6.4% cross slope
Solution: Demolish existing and construct new route
Bar. Severity: 1 Necessary Cost Estimate: $21,750.00 Status:
Implementation Priority: 4 Facility Function:
Implementation Phase: Implementation Date:
Official Responsible:
Notes:

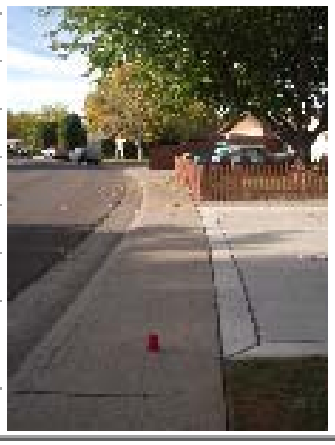
Field Date: 11/4/2010 Report Date: 11/4/2010 Barrier #: 2010

Location: Franela Wy - West
X Coordinate: -121.30378
Y Coordinate: 38.69621
Barrier Area: Sidewalks
Barrier Type: Cross Slope - Existing (5.0% or more)
Code Ref: CBC 1133B.7.1 and ADA/ABA 303.3
As Built Meas: 250 Quantity: LF
Description: Cross slope exceeds 2.0% (5.0% or more)
As Built Desc: 5.0% cross slope
Solution: Demolish existing and construct new route
Bar. Severity: 1 Necessary Cost Estimate: $31,250.00 Status:
Implementation Priority: 4 Facility Function:
Implementation Phase: Implementation Date:
Official Responsible:
Notes:

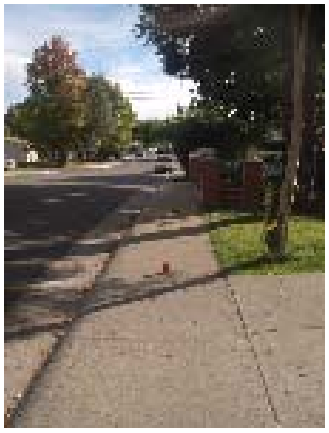
Field Date: 11/4/2010 Report Date: 11/4/2010 Barrier #: 2013

Location: Franela Wy - South
X Coordinate: -121.30563
Y Coordinate: 38.69556
Barrier Area: Sidewalks
Barrier Type: Cross Slope - Existing (5.0% or more)
Code Ref: CBC 1133B.7.1 and ADA/ABA 303.3
As Built Meas: 421 Quantity: LF
Description: Cross slope exceeds 2.0% (5.0% or more)
As Built Desc: 5.1% cross slope
Solution: Demolish existing and construct new route
Bar. Severity: 1 Necessary Cost Estimate: $52,625.00 Status:
Implementation Priority: 4 Facility Function:
Implementation Phase: Implementation Date:
Official Responsible:
Notes:

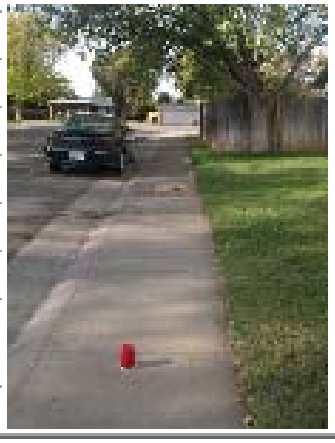
Location: Regan Ct - North
X Coordinate: -121.30253
Y Coordinate: 38.69588
Barrier Area: Sidewalks
Barrier Type: Cross Slope - Existing (4.1% to 4.9%)
Code Ref: CBC 1133B.7.1.3 and ADA/ABA 403.3
As Built Meas: 221 Quantity: LF
Description: Cross slope exceeds 2.0% (4.1% to 4.9%)
As Built Desc: 4.2% cross slope
Solution: Demolish existing and construct new route
Bar. Severity: 2 Recommended Cost Estimate: $27,625.00 Status:
Implementation Priority: 4 Facility Function:
Implementation Phase: Implementation Date:
Official Responsible:
Notes:

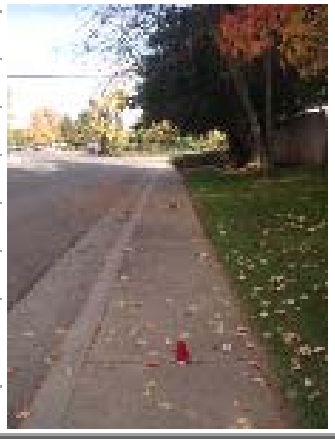
Field Date: 11/4/2010 Report Date: 11/4/2010 Barrier #: 2026

Location: Baranga Dr - East
X Coordinate: -121.30202
Y Coordinate: 38.69502
Barrier Area: Sidewalks
Barrier Type: Cross Slope - Existing (5.0% or more)
Code Ref: CBC 1133B.7.1 and ADA/ABA 303.3
As Built Meas: 134 Quantity: LF
Description: Cross slope exceeds 2.0% (5.0% or more)
As Built Desc: 5.2% cross slope
Solution: Demolish existing and construct new route
Bar. Severity: 1 Necessary Cost Estimate: $16,750.00 Status:
Implementation Priority: 4 Facility Function:
Implementation Phase: Implementation Date:
Official Responsible:
Notes:

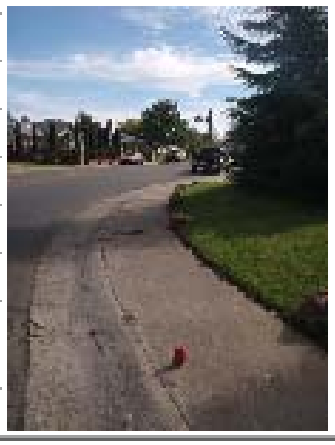
Field Date: 11/4/2010 Report Date: 11/4/2010 Barrier #: 2032

Location: Calvin Dr - South
X Coordinate: -121.29951
Y Coordinate: 38.69872
Barrier Area: Sidewalks
Barrier Type: Cross Slope - Existing (5.0% or more)
Code Ref: CBC 1133B.7.1 and ADA/ABA 303.3
As Built Meas: 246 Quantity: LF
Description: Cross slope exceeds 2.0% (5.0% or more)
As Built Desc: 5.5% cross slope
Solution: Demolish existing and construct new route
Bar. Severity: 1 Necessary Cost Estimate: $30,750.00 Status:
Implementation Priority: 4 Facility Function:
Implementation Phase: Implementation Date:
Official Responsible:
Notes:

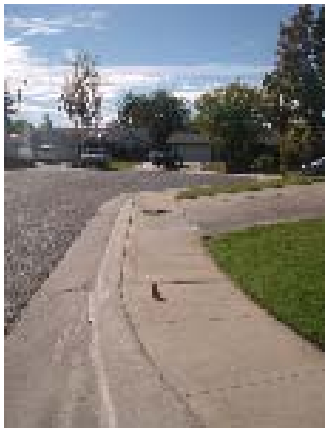
Field Date: 11/4/2010 Report Date: 11/4/2010 Barrier #: 2035
Location: Minuet Wy and Coronet Ct - Corner D
X Coordinate: -121.29881
Y Coordinate: 38.69638
Barrier Area: Curb Ramps
Barrier Type: No Curb Ramp
Code Ref: CBC 1127B.5.3 and ADA/ABA 406.2
As Built Meas: 1 Quantity: EACH
Description: No curb cut at corner (intersection)
As Built Desc: No curb ramp at corner
Solution: Demolish existing and construct curb cut
Bar. Severity: 1 Necessary Cost Estimate: $2,500.00 Status:
Implementation Priority: 4 Facility Function:
Implementation Phase: Implementation Date:
Official Responsible:
Notes: Two - way intersection corners C,D

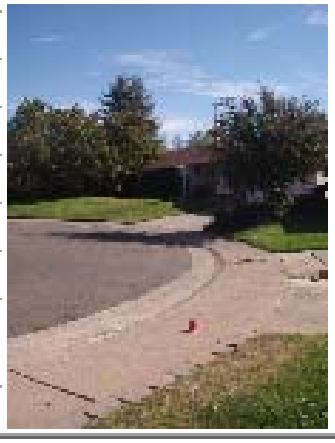
Field Date: 11/4/2010 Report Date: 11/4/2010 Barrier #: 2043

Location: Witchinghour Ct - North
X Coordinate: -121.29916
Y Coordinate: 38.69534
Barrier Area: Sidewalks
Barrier Type: Cross Slope - Existing (5.0% or more)
Code Ref: CBC 1133B.7.1 and ADA/ABA 303.3
As Built Meas: 91 Quantity: LF
Description: Cross slope exceeds 2.0% (5.0% or more)
As Built Desc: 5.9% cross slope
Solution: Demolish existing and construct new route
Bar. Severity: 1 Necessary Cost Estimate: $11,375.00 Status:
Implementation Priority: 4 Facility Function:
Implementation Phase: Implementation Date:
Official Responsible:
Notes:

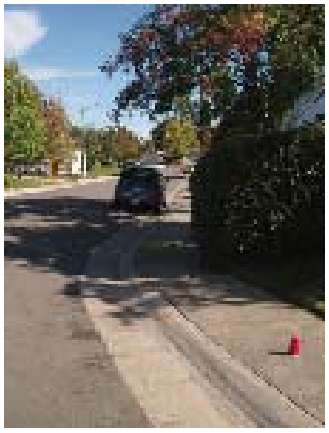
Field Date: 11/4/2010 Report Date: 11/4/2010 Barrier #: 2044

Location: Witchinghour Ct - South
X Coordinate: -121.29884
Y Coordinate: 38.69528
Barrier Area: Sidewalks
Barrier Type: Cross Slope - Existing (5.0% or more)
Code Ref: CBC 1133B.7.1 and ADA/ABA 303.3
As Built Meas: 280 Quantity: LF
Description: Cross slope exceeds 2.0% (5.0% or more)
As Built Desc: 6.2% cross slope
Solution: Demolish existing and construct new route
Bar. Severity: 1 Necessary Cost Estimate: $35,000.00 Status:
Implementation Priority: 4 Facility Function:
Implementation Phase: Implementation Date:
Official Responsible:
Notes:

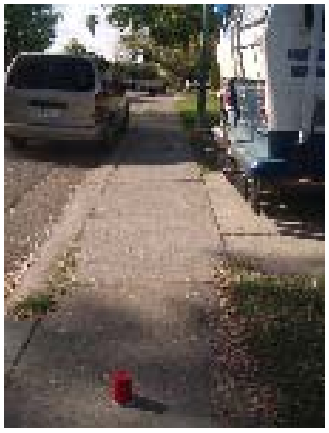
Field Date: 11/4/2010 Report Date: 11/4/2010 Barrier #: 2047C
Location: Winlock Ave and Raintree Dr - Corner D
X Coordinate: -121.29778
Y Coordinate: 38.69449
Barrier Area: Curb Ramps
Barrier Type: Detectable Warnings - Truncated Domes
Code Ref: CBC 1127B.5.3 and ADA/ABA 406.2
As Built Meas: 1 Quantity: EACH
Description: No truncated domes provided at curb ramp
As Built Desc: No detectable warnings at curb ramp
Solution: Provide compliant truncated domes
Bar. Severity: 2 Recommended Cost Estimate: $0.00 Status:
Implementation Priority: 4 Facility Function:
Implementation Phase: Implementation Date:
Official Responsible:
Notes: Two - way intersection corners A,D

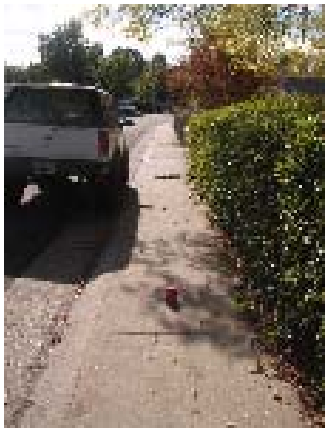
Field Date: 11/4/2010 Report Date: 11/4/2010 Barrier #: 2055

Location: Grenola Wy - North
X Coordinate: -121.3021
Y Coordinate: 38.69767
Barrier Area: Sidewalks
Barrier Type: Cross Slope - Existing (5.0% or more)
Code Ref: CBC 1133B.7.1 and ADA/ABA 303.3
As Built Meas: 284 Quantity: LF
Description: Cross slope exceeds 2.0% (5.0% or more)
As Built Desc: 5.2% cross slope
Solution: Demolish existing and construct new route
Bar. Severity: 1 Necessary Cost Estimate: $35,500.00 Status:
Implementation Priority: 4 Facility Function:
Implementation Phase: Implementation Date:
Official Responsible:
Notes:

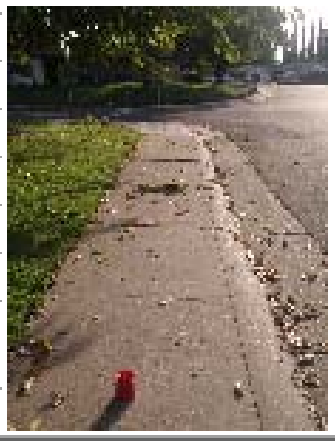
Field Date: 11/5/2010 Report Date: 11/5/2010 Barrier #: 2056A

Location: Winlock Ave - North
X Coordinate: -121.30031
Y Coordinate: 38.69493
Barrier Area: Sidewalks
Barrier Type: Cross Slope - Existing (5.0% or more)
Code Ref: CBC 1133B.7.1 and ADA/ABA 303.3
As Built Meas: 43 Quantity: LF
Description: Cross slope exceeds 2.0% (5.0% or more)
As Built Desc: 5.9% cross slope
Solution: Demolish existing and construct new route
Bar. Severity: 1 Necessary Cost Estimate: $5,375.00 Status:
Implementation Priority: 4 Facility Function:
Implementation Phase: Implementation Date:
Official Responsible:
Notes:

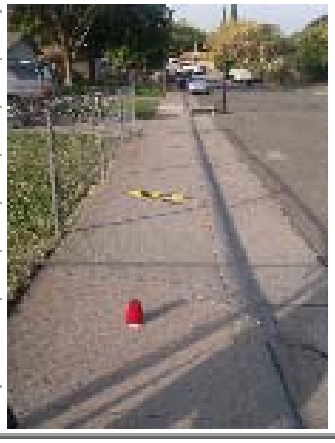
Field Date: 11/5/2010 Report Date: 11/5/2010 Barrier #: 2059A

Location: Noreen Wy - South
X Coordinate: -121.30067
Y Coordinate: 38.69562
Barrier Area: Sidewalks
Barrier Type: Cross Slope - Existing (5.0% or more)
Code Ref: CBC 1133B.7.1 and ADA/ABA 303.3
As Built Meas: 282 Quantity: LF
Description: Cross slope exceeds 2.0% (5.0% or more)
As Built Desc: 9.6% cross slope
Solution: Demolish existing and construct new route
Bar. Severity: 1 Necessary Cost Estimate: $35,250.00 Status:
Implementation Priority: 4 Facility Function:
Implementation Phase: Implementation Date:
Official Responsible:
Notes:

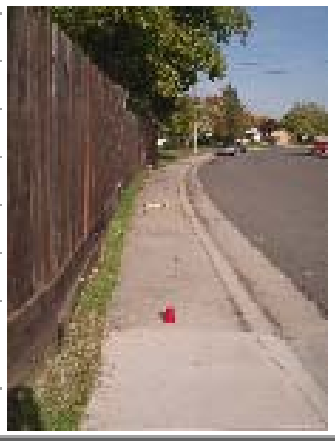
Field Date: 11/5/2010 Report Date: 11/5/2010 Barrier #: 2070

Location: Raintree Dr - West
X Coordinate: -121.29816
Y Coordinate: 38.69647
Barrier Area: Sidewalks
Barrier Type: Cross Slope - Existing (5.0% or more)
Code Ref: CBC 1133B.7.1 and ADA/ABA 303.3
As Built Meas: 463 Quantity: LF
Description: Cross slope exceeds 2.0% (5.0% or more)
As Built Desc: 5.6% cross slope
Solution: Demolish existing and construct new route
Bar. Severity: 1 Necessary Cost Estimate: $57,875.00 Status:
Implementation Priority: 4 Facility Function:
Implementation Phase: Implementation Date:
Official Responsible:
Notes:

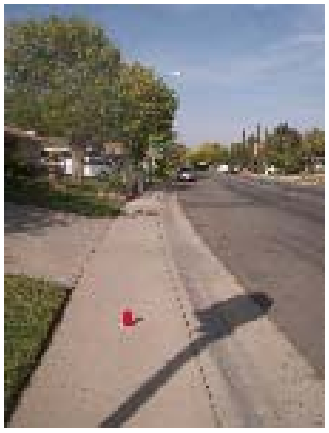
Field Date: 11/5/2010 Report Date: 11/5/2010 Barrier #: 2073
Location: Calvin Dr - South
X Coordinate: -121.29799
Y Coordinate: 38.69779
Barrier Area: Sidewalks
Barrier Type: Cross Slope - Existing (5.0% or more)
Code Ref: CBC 1133B.7.1 and ADA/ABA 303.3
As Built Meas: 242 Quantity: LF
Description: Cross slope exceeds 2.0% (5.0% or more)
As Built Desc: 5.2% cross slope
Solution: Demolish existing and construct new route
Bar. Severity: 1 Necessary Cost Estimate: $30,250.00 Status:
Implementation Priority: 4 Facility Function:
Implementation Phase: Implementation Date:
Official Responsible:
Notes:

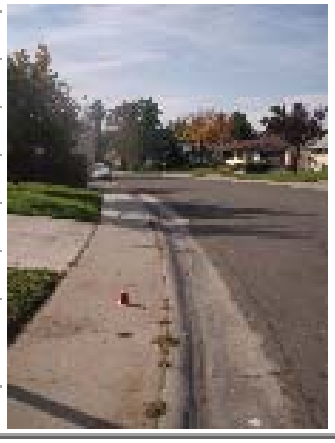
Field Date: 11/5/2010 Report Date: 11/5/2010 Barrier #: 2074

Location: Raintree Dr - East
X Coordinate: -121.29781
Y Coordinate: 38.69764
Barrier Area: Sidewalks
Barrier Type: Cross Slope - Existing (5.0% or more)
Code Ref: CBC 1133B.7.1 and ADA/ABA 303.3
As Built Meas: 611 Quantity: LF
Description: Cross slope exceeds 2.0% (5.0% or more)
As Built Desc: 5.5% cross slope
Solution: Demolish existing and construct new route
Bar. Severity: 1 Necessary Cost Estimate: $76,375.00 Status:
Implementation Priority: 4 Facility Function:
Implementation Phase: Implementation Date:
Official Responsible:
Notes:

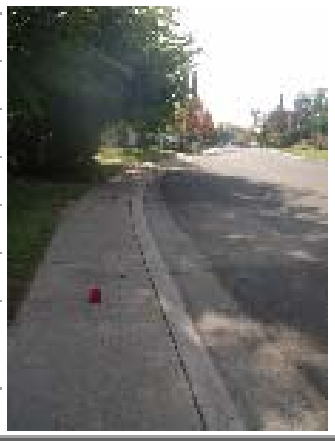
Field Date: 11/5/2010 Report Date: 11/5/2010 Barrier #: 2077

Location: Raintree Dr - East
X Coordinate: -121.29758
Y Coordinate: 38.69449
Barrier Area: Sidewalks
Barrier Type: Cross Slope - Existing (4.1% to 4.9%)
Code Ref: CBC 1133B.7.1.3 and ADA/ABA 403.3
As Built Meas: 342 Quantity: LF
Description: Cross slope exceeds 2.0% (4.1% to 4.9%)
As Built Desc: 4.3% cross slope
Solution: Demolish existing and construct new route
Bar. Severity: 2 Recommended Cost Estimate: $42,750.00 Status:
Implementation Priority: 4 Facility Function:
Implementation Phase: Implementation Date:
Official Responsible:
Notes:

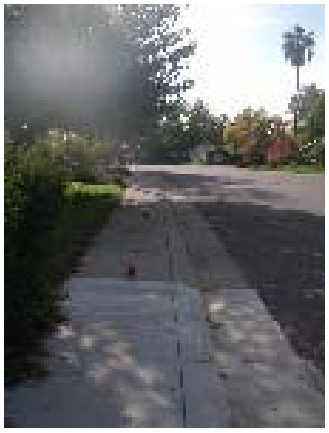
Field Date: 11/5/2010 Report Date: 11/5/2010 Barrier #: 2078

Location: Raintree Dr - East
X Coordinate: -121.29709
Y Coordinate: 38.69317
Barrier Area: Sidewalks
Barrier Type: Cross Slope - Existing (5.0% or more)
Code Ref: CBC 1133B.7.1 and ADA/ABA 303.3
As Built Meas: 657 Quantity: LF
Description: Cross slope exceeds 2.0% (5.0% or more)
As Built Desc: 8.7% cross slope
Solution: Demolish existing and construct new route
Bar. Severity: 1 Necessary Cost Estimate: $82,125.00 Status:
Implementation Priority: 4 Facility Function:
Implementation Phase: Implementation Date:
Official Responsible:
Notes:

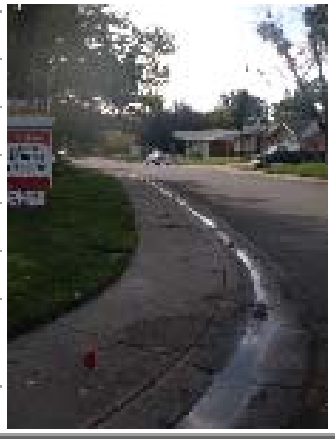
Field Date: 11/5/2010 Report Date: 11/5/2010 Barrier #: 2085

Location: Tandem Ct - East
X Coordinate: -121.2966
Y Coordinate: 38.69463
Barrier Area: Sidewalks
Barrier Type: Cross Slope - Existing (5.0% or more)
Code Ref: CBC 1133B.7.1 and ADA/ABA 303.3
As Built Meas: 443 Quantity: LF
Description: Cross slope exceeds 2.0% (5.0% or more)
As Built Desc: 6.2% cross slope
Solution: Demolish existing and construct new route
Bar. Severity: 1 Necessary Cost Estimate: $55,375.00 Status:
Implementation Priority: 4 Facility Function:
Implementation Phase: Implementation Date:
Official Responsible:
Notes:

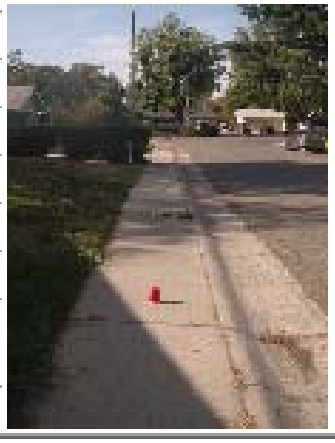
Field Date: 11/5/2010 Report Date: 11/5/2010 Barrier #: 2087

Location: Glass Slipper Wy - South
X Coordinate: -121.29482
Y Coordinate: 38.69415
Barrier Area: Sidewalks
Barrier Type: Cross Slope - Existing (5.0% or more)
Code Ref: CBC 1133B.7.1 and ADA/ABA 303.3
As Built Meas: 148 Quantity: LF
Description: Cross slope exceeds 2.0% (5.0% or more)
As Built Desc: 6.3% cross slope
Solution: Demolish existing and construct new route
Bar. Severity: 1 Necessary Cost Estimate: $18,500.00 Status:
Implementation Priority: 4 Facility Function:
Implementation Phase: Implementation Date:
Official Responsible:
Notes:

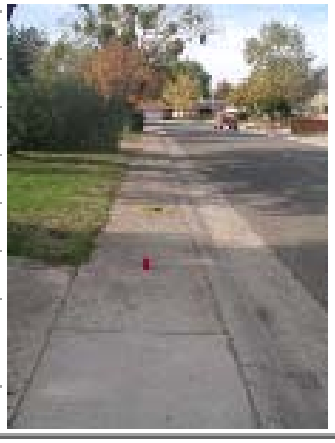
Field Date: 11/5/2010 Report Date: 11/5/2010 Barrier #: 2091A

Location: Three Sisters Ct - South
X Coordinate: -121.29597
Y Coordinate: 38.69532
Barrier Area: Sidewalks
Barrier Type: Cross Slope - Existing (5.0% or more)
Code Ref: CBC 1133B.7.1 and ADA/ABA 303.3
As Built Meas: 324 Quantity: LF
Description: Cross slope exceeds 2.0% (5.0% or more)
As Built Desc: 6.1% cross slope
Solution: Demolish existing and construct new route
Bar. Severity: 1 Necessary Cost Estimate: $40,500.00 Status:
Implementation Priority: 4 Facility Function:
Implementation Phase: Implementation Date:
Official Responsible:
Notes:

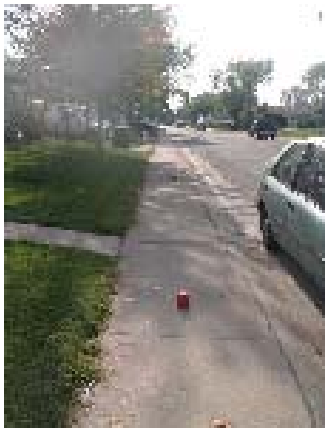
Field Date: 11/5/2010 Report Date: 11/5/2010 Barrier #: 2096
Location: Glass Slipper Wy - West
X Coordinate: -121.29544
Y Coordinate: 38.69595
Barrier Area: Sidewalks
Barrier Type: Cross Slope - Existing (5.0% or more)
Code Ref: CBC 1133B.7.1 and ADA/ABA 303.3
As Built Meas: 818 Quantity: LF
Description: Cross slope exceeds 2.0% (5.0% or more)
As Built Desc: 7.7% cross slope
Solution: Demolish existing and construct new route
Bar. Severity: 1 Necessary Cost Estimate: $102,250.00 Status:
Implementation Priority: 4 Facility Function:
Implementation Phase: Implementation Date:
Official Responsible:
Notes:

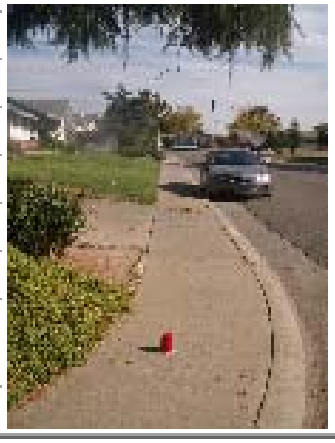
Field Date: 11/5/2010 Report Date: 11/5/2010 Barrier #: 2097

Location: Glass Slipper Wy - North
X Coordinate: -121.29522
Y Coordinate: 38.69415
Barrier Area: Sidewalks
Barrier Type: Cross Slope - Existing (5.0% or more)
Code Ref: CBC 1133B.7.1 and ADA/ABA 303.3
As Built Meas: 196 Quantity: LF
Description: Cross slope exceeds 2.0% (5.0% or more)
As Built Desc: 5.0% cross slope
Solution: Demolish existing and construct new route
Bar. Severity: 1 Necessary Cost Estimate: $24,500.00 Status:
Implementation Priority: 4 Facility Function:
Implementation Phase: Implementation Date:
Official Responsible:
Notes:

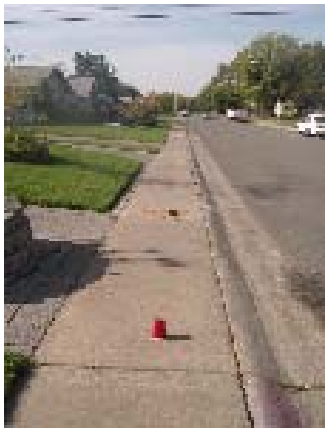
Field Date: 11/5/2010 Report Date: 11/5/2010 Barrier #: 2098

Location: Midnight Wy -South
X Coordinate: -121.29475
Y Coordinate: 38.69605
Barrier Area: Sidewalks
Barrier Type: Cross Slope - Existing (5.0% or more)
Code Ref: CBC 1133B.7.1 and ADA/ABA 303.3
As Built Meas: 124 Quantity: LF
Description: Cross slope exceeds 2.0% (5.0% or more)
As Built Desc: 5.1% cross slope
Solution: Demolish existing and construct new route
Bar. Severity: 1 Necessary Cost Estimate: $15,500.00 Status:
Implementation Priority: 4 Facility Function:
Implementation Phase: Implementation Date:
Official Responsible:
Notes:

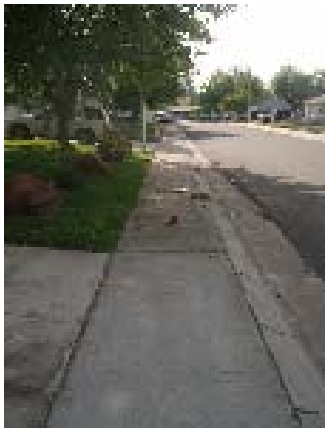
Field Date: 11/5/2010 Report Date: 11/5/2010 Barrier #: 2105A

Location: Candlelight Wy - East
X Coordinate: -121.29607
Y Coordinate: 38.6969
Barrier Area: Sidewalks
Barrier Type: Cross Slope - Existing (5.0% or more)
Code Ref: CBC 1133B.7.1 and ADA/ABA 303.3
As Built Meas: 384 Quantity: LF
Description: Cross slope exceeds 2.0% (5.0% or more)
As Built Desc: 7.3% cross slope
Solution: Demolish existing and construct new route
Bar. Severity: 1 Necessary Cost Estimate: $48,000.00 Status:
Implementation Priority: 4 Facility Function:
Implementation Phase: Implementation Date:
Official Responsible:
Notes:

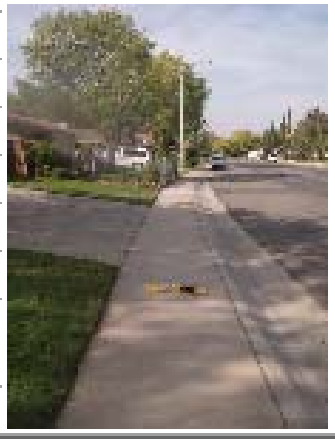
Field Date: 11/5/2010 Report Date: 11/5/2010 Barrier #: 2113

Location: Calvin Dr - South
X Coordinate: -121.29801
Y Coordinate: 38.6978
Barrier Area: Sidewalks
Barrier Type: Cross Slope - Existing (5.0% or more)
Code Ref: CBC 1133B.7.1 and ADA/ABA 303.3
As Built Meas: 168 Quantity: LF
Description: Cross slope exceeds 2.0% (5.0% or more)
As Built Desc: 5.3% cross slope
Solution: Demolish existing and construct new route
Bar. Severity: 1 Necessary Cost Estimate: $21,000.00 Status:
Implementation Priority: 4 Facility Function:
Implementation Phase: Implementation Date:
Official Responsible:
Notes:

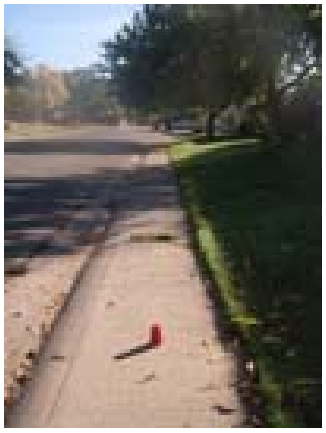
Field Date: 11/9/2010 Report Date: 11/9/2010 Barrier #: 2114

Location: Winlock Ave - South
X Coordinate: -121.30173
Y Coordinate: 38.69483
Barrier Area: Sidewalks
Barrier Type: Cross Slope - Existing (5.0% or more)
Code Ref: CBC 1133B.7.1 and ADA/ABA 303.3
As Built Meas: 138 Quantity: LF
Description: Cross slope exceeds 2.0% (5.0% or more)
As Built Desc: 5.3% cross slope
Solution: Demolish existing and construct new route
Bar. Severity: 1 Necessary Cost Estimate: $17,250.00 Status:
Implementation Priority: 4 Facility Function:
Implementation Phase: Implementation Date:
Official Responsible:
Notes:

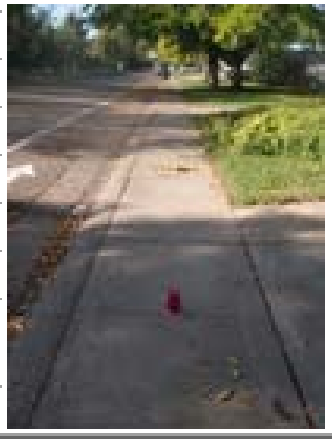
Field Date: 11/9/2010 Report Date: 11/9/2010 Barrier #: 2124

Location: Auburn Blvd Frontage Rd - North
X Coordinate: -121.29723
Y Coordinate: 38.69258
Barrier Area: Sidewalks
Barrier Type: Cross Slope - Existing (5.0% or more)
Code Ref: CBC 1133B.7.1 and ADA/ABA 303.3
As Built Meas: 165 Quantity: LF
Description: Cross slope exceeds 2.0% (5.0% or more)
As Built Desc: 5.9% cross slope
Solution: Demolish existing and construct new route
Bar. Severity: 1 Necessary Cost Estimate: $20,625.00 Status:
Implementation Priority: 1 Facility Function:
Implementation Phase: Implementation Date:
Official Responsible:
Notes:

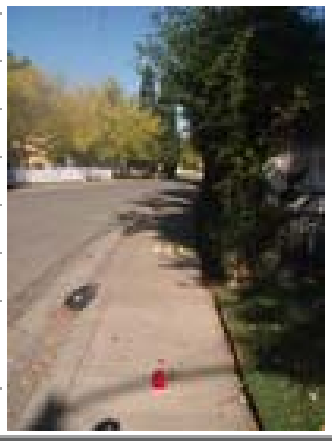
Field Date: 11/9/2010 Report Date: 11/9/2010 Barrier #: 2129A

Location: Coachman Wy - East
X Coordinate: -121.29882
Y Coordinate: 38.69216
Barrier Area: Sidewalks
Barrier Type: Cross Slope - Existing (5.0% or more)
Code Ref: CBC 1133B.7.1 and ADA/ABA 303.3
As Built Meas: 213 Quantity: LF
Description: Cross slope exceeds 2.0% (5.0% or more)
As Built Desc: 5.2% cross slope
Solution: Demolish existing and construct new route
Bar. Severity: 1 Necessary Cost Estimate: $26,625.00 Status:
Implementation Priority: 4 Facility Function:
Implementation Phase: Implementation Date:
Official Responsible:
Notes:

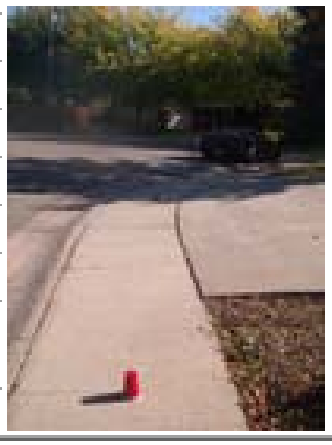
Field Date: 11/9/2010 Report Date: 11/9/2010 Barrier #: 2132B

Location: Magic Ct - South
X Coordinate: -121.29865
Y Coordinate: 38.69288
Barrier Area: Sidewalks
Barrier Type: Cross Slope - Existing (5.0% or more)
Code Ref: CBC 1133B.7.1 and ADA/ABA 303.3
As Built Meas: 102 Quantity: LF
Description: Cross slope exceeds 2.0% (5.0% or more)
As Built Desc: 5.3% cross slope
Solution: Demolish existing and construct new route
Bar. Severity: 1 Necessary Cost Estimate: $12,750.00 Status:
Implementation Priority: 4 Facility Function:
Implementation Phase: Implementation Date:
Official Responsible:
Notes:

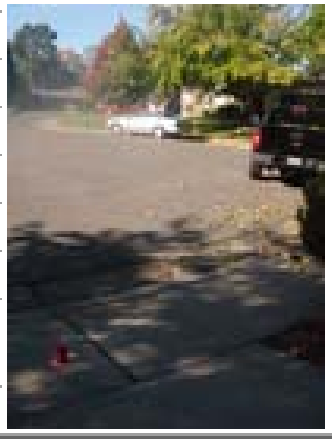
Field Date: 11/9/2010 Report Date: 11/9/2010 Barrier #: 2133

Location: Magic Ct - North
X Coordinate: -121.2981
Y Coordinate: 38.69307
Barrier Area: Sidewalks
Barrier Type: Cross Slope - Existing (5.0% or more)
Code Ref: CBC 1133B.7.1 and ADA/ABA 303.3
As Built Meas: 153 Quantity: LF
Description: Cross slope exceeds 2.0% (5.0% or more)
As Built Desc: 5.2% cross slope
Solution: Demolish existing and construct new route
Bar. Severity: 1 Necessary Cost Estimate: $19,125.00 Status:
Implementation Priority: 4 Facility Function:
Implementation Phase: Implementation Date:
Official Responsible:
Notes:

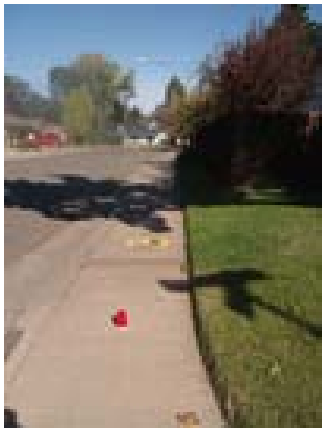
Field Date: 11/9/2010 Report Date: 11/9/2010 Barrier #: 2134A

Location: Coachman Wy - East
X Coordinate: -121.29898
Y Coordinate: 38.69305
Barrier Area: Sidewalks
Barrier Type: Cross Slope - Existing (5.0% or more)
Code Ref: CBC 1133B.7.1 and ADA/ABA 303.3
As Built Meas: 240 Quantity: LF
Description: Cross slope exceeds 2.0% (5.0% or more)
As Built Desc: 9.4% cross slope
Solution: Demolish existing and construct new route
Bar. Severity: 1 Necessary Cost Estimate: $30,000.00 Status:
Implementation Priority: 4 Facility Function:
Implementation Phase: Implementation Date:
Official Responsible:
Notes:

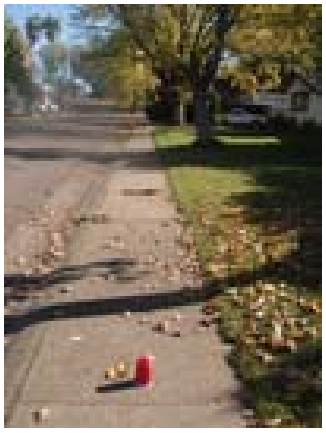
Field Date:	11/9/2010
Report Date:	11/9/2010
Barrier #:	2134B
Location:	Coachman Wy - East
X Coordinate:	-121.29896
Y Coordinate:	38.69351
Barrier Area:	Sidewalks
Barrier Type:	Abrupt Change in Level - > 1/2"
Code Ref:	CBC 1133B.7.1 and ADA/ABA 303.3
As Built Meas:	4
Quantity:	LF
Description:	Change in level greater than 1/2"
As Built Desc:	1/2" lip in sidewalk surface
Solution:	Grind or repair sidewalk to remove trip hazard
Bar. Severity:	1 Necessary
Cost Estimate:	$1,000.00
Status:	
Implementation Priority:	4
Facility Function:	
Implementation Phase:	
Implementation Date:	
Official Responsible:	
Notes:

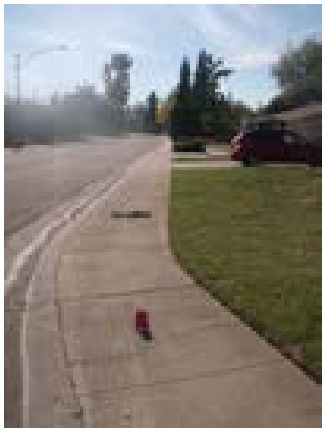
Field Date: 11/9/2010 Report Date: 11/9/2010 Barrier #: 2137

Location: Coachman Wy - West
X Coordinate: -121.29896
Y Coordinate: 38.69219
Barrier Area: Sidewalks
Barrier Type: Cross Slope - Existing (5.0% or more)
Code Ref: CBC 1133B.7.1 and ADA/ABA 303.3
As Built Meas: 481 Quantity: LF
Description: Cross slope exceeds 2.0% (5.0% or more)
As Built Desc: 10.4% cross slope
Solution: Demolish existing and construct new route
Bar. Severity: 1 Necessary Cost Estimate: $60,125.00 Status:
Implementation Priority: 4 Facility Function:
Implementation Phase: Implementation Date:
Official Responsible:
Notes:

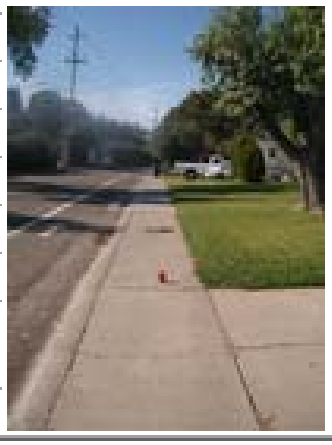
Field Date: 11/9/2010 Report Date: 11/9/2010 Barrier #: 2138

Location: Auburn Blvd Frontage Rd - North
X Coordinate: -121.29916
Y Coordinate: 38.6919
Barrier Area: Sidewalks
Barrier Type: Cross Slope - Existing (5.0% or more)
Code Ref: CBC 1133B.7.1 and ADA/ABA 303.3
As Built Meas: 1215 Quantity: LF
Description: Cross slope exceeds 2.0% (5.0% or more)
As Built Desc: 5.5% cross slope
Solution: Demolish existing and construct new route
Bar. Severity: 1 Necessary Cost Estimate: $151,875.00 Status:
Implementation Priority: 1 Facility Function:
Implementation Phase: Implementation Date:
Official Responsible:
Notes:
