CITY OF CITRUS HEIGHTS

DRAFT ADA TRANSITION PLAN UPDATE

NEIGHBORHOOD AREA 2 RUSCH PARK

SEPTEMBER 20, 2011

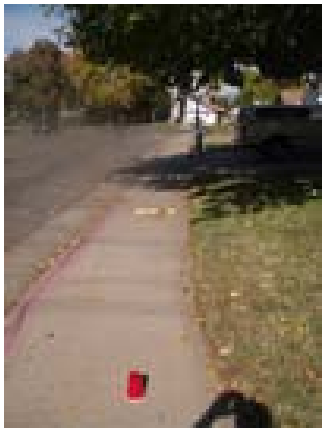
Field Date: 11/9/2010 Report Date: 11/9/2010 Barrier #: 2139

Location: San Tomas Dr - East
X Coordinate: -121.30166
Y Coordinate: 38.6911
Barrier Area: Sidewalks
Barrier Type: Cross Slope - Existing (5.0% or more)
Code Ref: CBC 1133B.7.1 and ADA/ABA 303.3
As Built Meas: 200 Quantity: LF
Description: Cross slope exceeds 2.0% (5.0% or more)
As Built Desc: 5.5% cross slope
Solution: Demolish existing and construct new route
Bar. Severity: 1 Necessary Cost Estimate: $25,000.00 Status:
Implementation Priority: 4 Facility Function:
Implementation Phase: Implementation Date:
Official Responsible:
Notes:

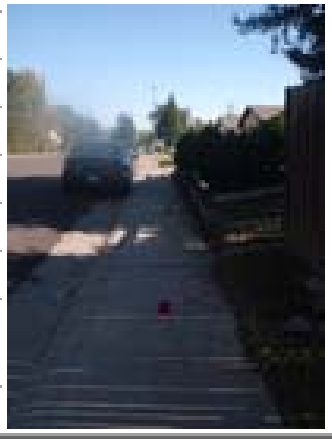
Field Date: 11/9/2010 Report Date: 11/9/2010 Barrier #: 2140

Location: Westchester Wy - South
X Coordinate: -121.30155
Y Coordinate: 38.69173
Barrier Area: Sidewalks
Barrier Type: Cross Slope - Existing (5.0% or more)
Code Ref: CBC 1133B.7.1 and ADA/ABA 303.3
As Built Meas: 500 Quantity: LF
Description: Cross slope exceeds 2.0% (5.0% or more)
As Built Desc: 6.5% cross slope
Solution: Demolish existing and construct new route
Bar. Severity: 1 Necessary Cost Estimate: $62,500.00 Status:
Implementation Priority: 4 Facility Function:
Implementation Phase: Implementation Date:
Official Responsible:
Notes:

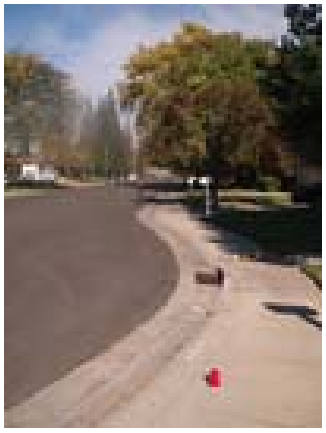
Field Date: 11/9/2010 Report Date: 11/9/2010 Barrier #: 2141

Location: Westchester Wy - East
X Coordinate: -121.29991
Y Coordinate: 38.69229
Barrier Area: Sidewalks
Barrier Type: Cross Slope - Existing (5.0% or more)
Code Ref: CBC 1133B.7.1 and ADA/ABA 303.3
As Built Meas: 812 Quantity: LF
Description: Cross slope exceeds 2.0% (5.0% or more)
As Built Desc: 7.6% cross slope
Solution: Demolish existing and construct new route
Bar. Severity: 1 Necessary Cost Estimate: $101,500.00 Status:
Implementation Priority: 4 Facility Function:
Implementation Phase: Implementation Date:
Official Responsible:
Notes:

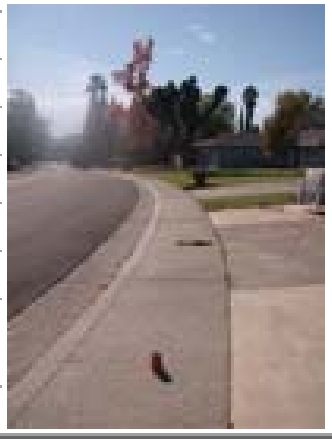
Field Date: 11/9/2010 Report Date: 11/9/2010 Barrier #: 2142

Location: Westchester Wy - West
X Coordinate: -121.30001
Y Coordinate: 38.6945
Barrier Area: Sidewalks
Barrier Type: Cross Slope - Existing (5.0% or more)
Code Ref: CBC 1133B.7.1 and ADA/ABA 303.3
As Built Meas: 743 Quantity: LF
Description: Cross slope exceeds 2.0% (5.0% or more)
As Built Desc: 5.2% cross slope
Solution: Demolish existing and construct new route
Bar. Severity: 1 Necessary Cost Estimate: $92,875.00 Status:
Implementation Priority: 4 Facility Function:
Implementation Phase: Implementation Date:
Official Responsible:
Notes:

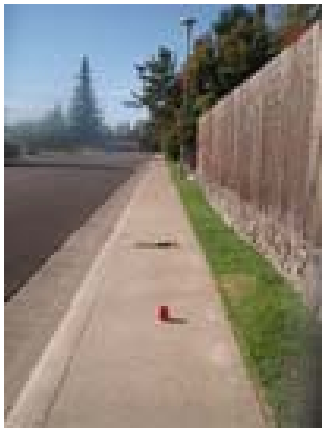
Field Date: 11/9/2010 Report Date: 11/9/2010 Barrier #: 2143

Location: Westchester Wy - North
X Coordinate: -121.30015
Y Coordinate: 38.6923
Barrier Area: Sidewalks
Barrier Type: Cross Slope - Existing (5.0% or more)
Code Ref: CBC 1133B.7.1 and ADA/ABA 303.3
As Built Meas: 140 Quantity: LF
Description: Cross slope exceeds 2.0% (5.0% or more)
As Built Desc: 5.5% cross slope
Solution: Demolish existing and construct new route
Bar. Severity: 1 Necessary Cost Estimate: $17,500.00 Status:
Implementation Priority: 4 Facility Function:
Implementation Phase: Implementation Date:
Official Responsible:
Notes:

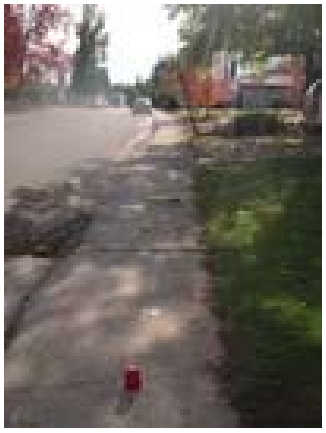
Field Date: 11/9/2010 Report Date: 11/9/2010 Barrier #: 2144C
Location: Cassini Wy - East
X Coordinate: -121.30081
Y Coordinate: 38.69234
Barrier Area: Sidewalks
Barrier Type: Abrupt Change in Level - > 1/2"
Code Ref: CBC 1133B.7.1 and ADA/ABA 303.3
As Built Meas: 4 Quantity: LF
Description: Change in level greater than 1/2"
As Built Desc: 1/2" lip in sidewalk surface
Solution: Grind or repair sidewalk to remove trip hazard
Bar. Severity: 1 Necessary Cost Estimate: $1,000.00 Status:
Implementation Priority: 4 Facility Function:
Implementation Phase: Implementation Date:
Official Responsible:
Notes:

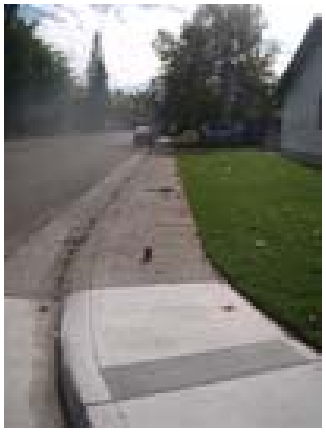
Field Date: 11/9/2010 Report Date: 11/9/2010 Barrier #: 2147

Location: Cassini Wy - West
X Coordinate: -121.301
Y Coordinate: 38.69311
Barrier Area: Sidewalks
Barrier Type: Cross Slope - Existing (5.0% or more)
Code Ref: CBC 1133B.7.1 and ADA/ABA 303.3
As Built Meas: 318 Quantity: LF
Description: Cross slope exceeds 2.0% (5.0% or more)
As Built Desc: 5.6% cross slope
Solution: Demolish existing and construct new route
Bar. Severity: 1 Necessary Cost Estimate: $39,750.00 Status:
Implementation Priority: 4 Facility Function:
Implementation Phase: Implementation Date:
Official Responsible:
Notes:

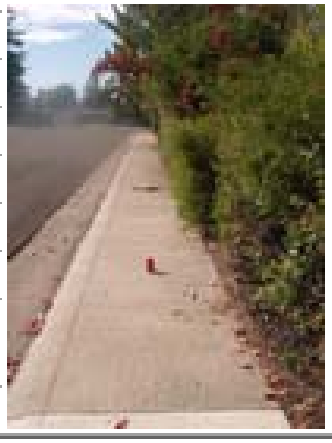
Field Date: 11/9/2010 Report Date: 11/9/2010 Barrier #: 2148

Location: Westchester Wy - North
X Coordinate: -121.30089
Y Coordinate: 38.69205
Barrier Area: Sidewalks
Barrier Type: Cross Slope - Existing (5.0% or more)
Code Ref: CBC 1133B.7.1 and ADA/ABA 303.3
As Built Meas: 165 Quantity: LF
Description: Cross slope exceeds 2.0% (5.0% or more)
As Built Desc: 5.1% cross slope
Solution: Demolish existing and construct new route
Bar. Severity: 1 Necessary Cost Estimate: $20,625.00 Status:
Implementation Priority: 4 Facility Function:
Implementation Phase: Implementation Date:
Official Responsible:
Notes:

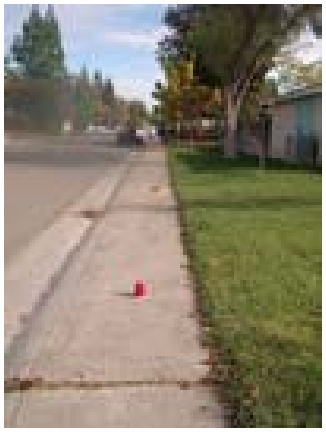
Field Date: 11/9/2010 Report Date: 11/9/2010 Barrier #: 2160

Location: Kittery Ave - South
X Coordinate: -121.30373
Y Coordinate: 38.69223
Barrier Area: Sidewalks
Barrier Type: Cross Slope - Existing (4.1% to 4.9%)
Code Ref: CBC 1133B.7.1.3 and ADA/ABA 403.3
As Built Meas: 381 Quantity: LF
Description: Cross slope exceeds 2.0% (4.1% to 4.9%)
As Built Desc: 4.9% cross slope
Solution: Demolish existing and construct new route
Bar. Severity: 2 Recommended Cost Estimate: $47,625.00 Status:
Implementation Priority: 4 Facility Function:
Implementation Phase: Implementation Date:
Official Responsible:
Notes:

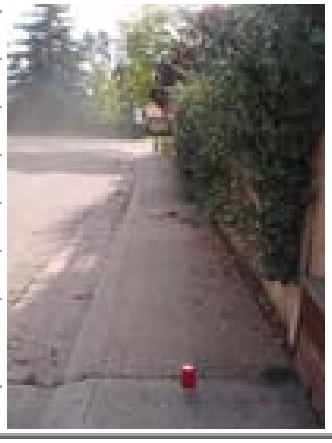
Field Date: 11/9/2010 Report Date: 11/9/2010 Barrier #: 2161

Location: Kittery Ave - West
X Coordinate: -121.30179
Y Coordinate: 38.69208
Barrier Area: Sidewalks
Barrier Type: Cross Slope - Existing (5.0% or more)
Code Ref: CBC 1133B.7.1 and ADA/ABA 303.3
As Built Meas: 40 Quantity: LF
Description: Cross slope exceeds 2.0% (5.0% or more)
As Built Desc: 5.0% cross slope
Solution: Demolish existing and construct new route
Bar. Severity: 1 Necessary Cost Estimate: $5,000.00 Status:
Implementation Priority: 4 Facility Function:
Implementation Phase: Implementation Date:
Official Responsible:
Notes:

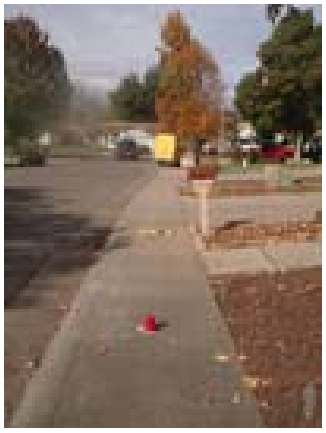
Field Date: 11/9/2010 Report Date: 11/9/2010 Barrier #: 2162

Location: Kittery Ave - East
X Coordinate: -121.30162
Y Coordinate: 38.69192
Barrier Area: Sidewalks
Barrier Type: Cross Slope - Existing (5.0% or more)
Code Ref: CBC 1133B.7.1 and ADA/ABA 303.3
As Built Meas: 50 Quantity: LF
Description: Cross slope exceeds 2.0% (5.0% or more)
As Built Desc: 5.2% cross slope
Solution: Demolish existing and construct new route
Bar. Severity: 1 Necessary Cost Estimate: $6,250.00 Status:
Implementation Priority: 4 Facility Function:
Implementation Phase: Implementation Date:
Official Responsible:
Notes:

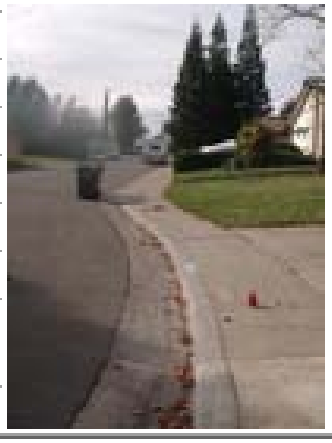
Field Date: 11/9/2010 Report Date: 11/9/2010 Barrier #: 2163

Location: Kittery Ave -North
X Coordinate: -121.30182
Y Coordinate: 38.69239
Barrier Area: Sidewalks
Barrier Type: Cross Slope - Existing (5.0% or more)
Code Ref: CBC 1133B.7.1 and ADA/ABA 303.3
As Built Meas: 551 Quantity: LF
Description: Cross slope exceeds 2.0% (5.0% or more)
As Built Desc: 5.1% cross slope
Solution: Demolish existing and construct new route
Bar. Severity: 1 Necessary Cost Estimate: $68,875.00 Status:
Implementation Priority: 4 Facility Function:
Implementation Phase: Implementation Date:
Official Responsible:
Notes:

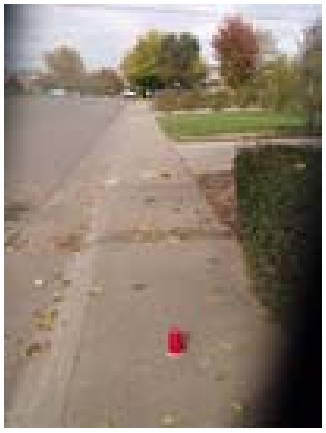
Field Date: 11/9/2010 Report Date: 11/9/2010 Barrier #: 2164A

Location: Cobalt Wy - East
X Coordinate: -121.30568
Y Coordinate: 38.69235
Barrier Area: Sidewalks
Barrier Type: Cross Slope - Existing (5.0% or more)
Code Ref: CBC 1133B.7.1 and ADA/ABA 303.3
As Built Meas: 30 Quantity: LF
Description: Cross slope exceeds 2.0% (5.0% or more)
As Built Desc: 6.2% cross slope
Solution: Demolish existing and construct new route
Bar. Severity: 1 Necessary Cost Estimate: $3,750.00 Status:
Implementation Priority: 4 Facility Function:
Implementation Phase: Implementation Date:
Official Responsible:
Notes:

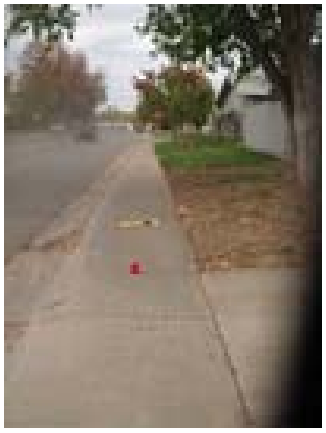
Field Date: 11/9/2010 Report Date: 11/9/2010 Barrier #: 2164B
Location: Cobalt Wy - East
X Coordinate: -121.30569
Y Coordinate: 38.69238
Barrier Area: Sidewalks
Barrier Type: Abrupt Change in Level - > 1/2"
Code Ref: CBC 1133B.7.1 and ADA/ABA 303.3
As Built Meas: 4 Quantity: LF
Description: Change in level greater than 1/2"
As Built Desc: 1/2" lip in sidewalk surface
Solution: Grind or repair sidewalk to remove trip hazard
Bar. Severity: 1 Necessary Cost Estimate: $1,000.00 Status:
Implementation Priority: 4 Facility Function:
Implementation Phase: Implementation Date:
Official Responsible:
Notes:

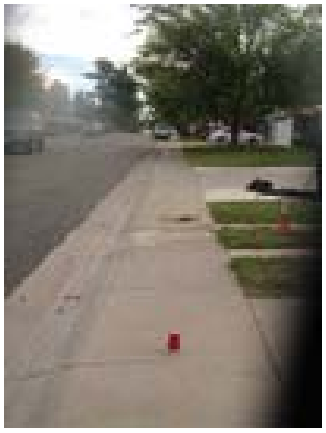
Field Date: 11/9/2010 Report Date: 11/9/2010 Barrier #: 2167

Location: Durham St - West
X Coordinate: -121.30493
Y Coordinate: 38.69414
Barrier Area: Sidewalks
Barrier Type: Cross Slope - Existing (4.1% to 4.9%)
Code Ref: CBC 1133B.7.1.3 and ADA/ABA 403.3
As Built Meas: 138 Quantity: LF
Description: Cross slope exceeds 2.0% (4.1% to 4.9%)
As Built Desc: 4.9% cross slope
Solution: Demolish existing and construct new route
Bar. Severity: 2 Recommended Cost Estimate: $17,250.00 Status:
Implementation Priority: 4 Facility Function:
Implementation Phase: Implementation Date:
Official Responsible:
Notes:

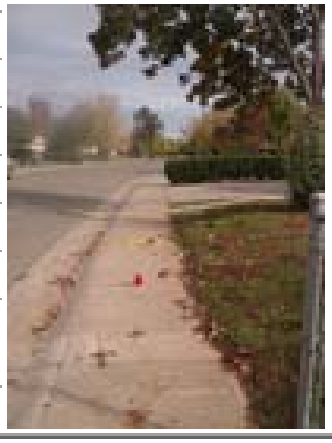
Field Date: 11/9/2010 Report Date: 11/9/2010 Barrier #: 2168

Location: Winlock Ave - South
X Coordinate: -121.30454
Y Coordinate: 38.69484
Barrier Area: Sidewalks
Barrier Type: Cross Slope - Existing (4.1% to 4.9%)
Code Ref: CBC 1133B.7.1.3 and ADA/ABA 403.3
As Built Meas: 60 Quantity: LF
Description: Cross slope exceeds 2.0% (4.1% to 4.9%)
As Built Desc: 4.6% cross slope
Solution: Demolish existing and construct new route
Bar. Severity: 2 Recommended Cost Estimate: $7,500.00 Status:
Implementation Priority: 4 Facility Function:
Implementation Phase: Implementation Date:
Official Responsible:
Notes:

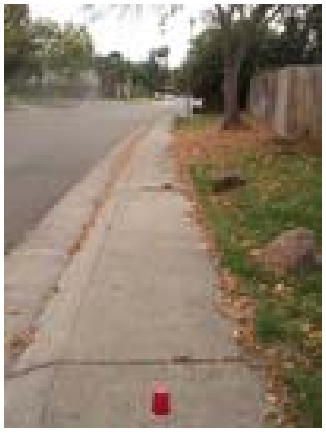
Field Date: 11/9/2010 Report Date: 11/9/2010 Barrier #: 2172

Location: Pippin Wy - West
X Coordinate: -121.30397
Y Coordinate: 38.69217
Barrier Area: Sidewalks
Barrier Type: Cross Slope - Existing (5.0% or more)
Code Ref: CBC 1133B.7.1 and ADA/ABA 303.3
As Built Meas: 200 Quantity: LF
Description: Cross slope exceeds 2.0% (5.0% or more)
As Built Desc: 5.8% cross slope
Solution: Demolish existing and construct new route
Bar. Severity: 1 Necessary Cost Estimate: $25,000.00 Status:
Implementation Priority: 4 Facility Function:
Implementation Phase: Implementation Date:
Official Responsible:
Notes:

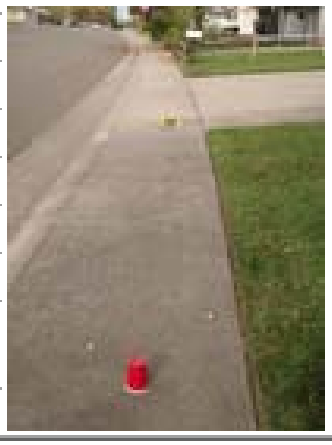
Field Date: 11/9/2010 Report Date: 11/9/2010 Barrier #: 2173

Location: Pippin Wy - East
X Coordinate: -121.30373
Y Coordinate: 38.69171
Barrier Area: Sidewalks
Barrier Type: Cross Slope - Existing (4.1% to 4.9%)
Code Ref: CBC 1133B.7.1.3 and ADA/ABA 403.3
As Built Meas: 200 Quantity: LF
Description: Cross slope exceeds 2.0% (4.1% to 4.9%)
As Built Desc: 4.4% cross slope
Solution: Demolish existing and construct new route
Bar. Severity: 2 Recommended Cost Estimate: $25,000.00 Status:
Implementation Priority: 4 Facility Function:
Implementation Phase: Implementation Date:
Official Responsible:
Notes:

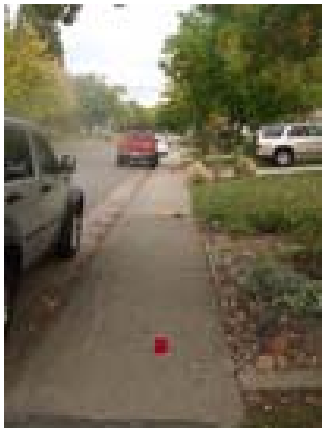
Field Date: 11/9/2010 Report Date: 11/9/2010 Barrier #: 2178

Location: Winlock Ave - South
X Coordinate: -121.3025
Y Coordinate: 38.69484
Barrier Area: Sidewalks
Barrier Type: Cross Slope - Existing (4.1% to 4.9%)
Code Ref: CBC 1133B.7.1.3 and ADA/ABA 403.3
As Built Meas: 130 Quantity: LF
Description: Cross slope exceeds 2.0% (4.1% to 4.9%)
As Built Desc: 4.1% cross slope
Solution: Demolish existing and construct new route
Bar. Severity: 2 Recommended Cost Estimate: $16,250.00 Status:
Implementation Priority: 4 Facility Function:
Implementation Phase: Implementation Date:
Official Responsible:
Notes:

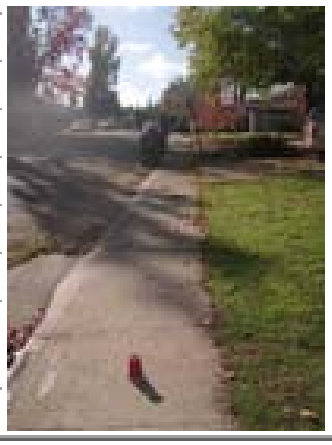
Field Date: 11/10/2010 Report Date: 11/10/2010 Barrier #: 2179

Location: Cassini Wy - West
X Coordinate: -121.30122
Y Coordinate: 38.69473
Barrier Area: Sidewalks
Barrier Type: Cross Slope - Existing (5.0% or more)
Code Ref: CBC 1133B.7.1 and ADA/ABA 303.3
As Built Meas: 314 Quantity: LF
Description: Cross slope exceeds 2.0% (5.0% or more)
As Built Desc: 7.2% cross slope
Solution: Demolish existing and construct new route
Bar. Severity: 1 Necessary Cost Estimate: $39,250.00 Status:
Implementation Priority: 4 Facility Function:
Implementation Phase: Implementation Date:
Official Responsible:
Notes:

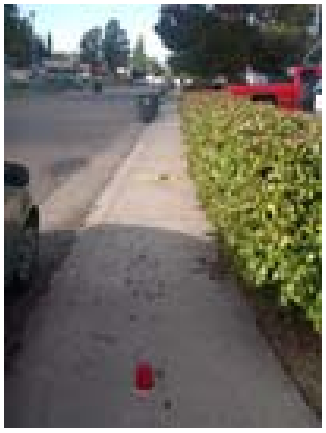
Field Date: 11/10/2010 Report Date: 11/10/2010 Barrier #: 2180

Location: Kaplan Wy - North
X Coordinate: -121.30109
Y Coordinate: 38.69382
Barrier Area: Sidewalks
Barrier Type: Cross Slope - Existing (5.0% or more)
Code Ref: CBC 1133B.7.1 and ADA/ABA 303.3
As Built Meas: 219 Quantity: LF
Description: Cross slope exceeds 2.0% (5.0% or more)
As Built Desc: 5.2% cross slope
Solution: Demolish existing and construct new route
Bar. Severity: 1 Necessary Cost Estimate: $27,375.00 Status:
Implementation Priority: 4 Facility Function:
Implementation Phase: Implementation Date:
Official Responsible:
Notes:

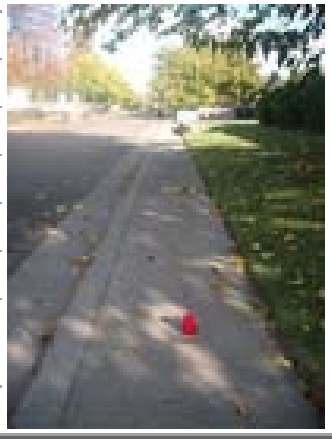
Field Date: 11/10/2010 Report Date: 11/10/2010 Barrier #: 2181

Location: Baranga Dr - East
X Coordinate: -121.30199
Y Coordinate: 38.6939
Barrier Area: Sidewalks
Barrier Type: Cross Slope - Existing (4.1% to 4.9%)
Code Ref: CBC 1133B.7.1.3 and ADA/ABA 403.3
As Built Meas: 222 Quantity: LF
Description: Cross slope exceeds 2.0% (4.1% to 4.9%)
As Built Desc: 4.7% cross slope
Solution: Demolish existing and construct new route
Bar. Severity: 2 Recommended Cost Estimate: $27,750.00 Status:
Implementation Priority: 4 Facility Function:
Implementation Phase: Implementation Date:
Official Responsible:
Notes:

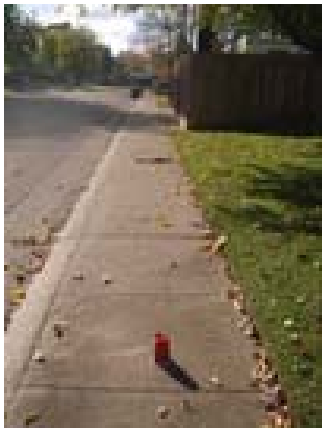
Field Date: 11/10/2010 Report Date: 11/10/2010 Barrier #: 2182

Location: Baranga Dr - West
X Coordinate: -121.30213
Y Coordinate: 38.69472
Barrier Area: Sidewalks
Barrier Type: Cross Slope - Existing (4.1% to 4.9%)
Code Ref: CBC 1133B.7.1.3 and ADA/ABA 403.3
As Built Meas: 225 Quantity: LF
Description: Cross slope exceeds 2.0% (4.1% to 4.9%)
As Built Desc: 4.7% cross slope
Solution: Demolish existing and construct new route
Bar. Severity: 2 Recommended Cost Estimate: $28,125.00 Status:
Implementation Priority: 4 Facility Function:
Implementation Phase: Implementation Date:
Official Responsible:
Notes:

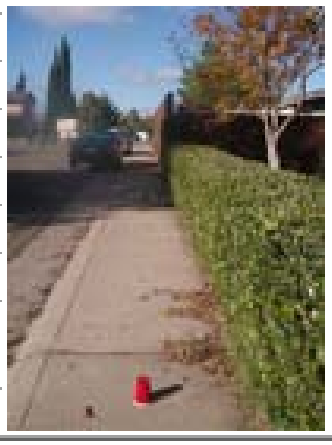
Field Date: 11/10/2010 Report Date: 11/10/2010 Barrier #: 2183

Location: Kaplan Wy - North
X Coordinate: -121.30224
Y Coordinate: 38.69378
Barrier Area: Sidewalks
Barrier Type: Cross Slope - Existing (5.0% or more)
Code Ref: CBC 1133B.7.1 and ADA/ABA 303.3
As Built Meas: 165 Quantity: LF
Description: Cross slope exceeds 2.0% (5.0% or more)
As Built Desc: 5.8% cross slope
Solution: Demolish existing and construct new route
Bar. Severity: 1 Necessary Cost Estimate: $20,625.00 Status:
Implementation Priority: 4 Facility Function:
Implementation Phase: Implementation Date:
Official Responsible:
Notes:

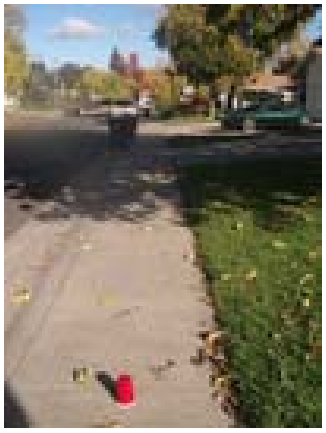
Field Date: 11/10/2010 Report Date: 11/10/2010 Barrier #: 2184

Location: Bonwit Wy - East
X Coordinate: -121.30294
Y Coordinate: 38.69385
Barrier Area: Sidewalks
Barrier Type: Cross Slope - Existing (4.1% to 4.9%)
Code Ref: CBC 1133B.7.1.3 and ADA/ABA 403.3
As Built Meas: 248 Quantity: LF
Description: Cross slope exceeds 2.0% (4.1% to 4.9%)
As Built Desc: 4.2% cross slope
Solution: Demolish existing and construct new route
Bar. Severity: 2 Recommended Cost Estimate: $31,000.00 Status:
Implementation Priority: 4 Facility Function:
Implementation Phase: Implementation Date:
Official Responsible:
Notes:

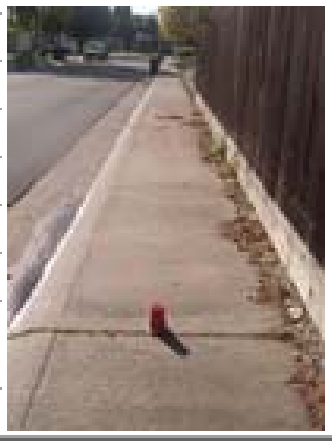
Field Date: 11/10/2010 Report Date: 11/10/2010 Barrier #: 2185

Location: Bonwit Wy - West
X Coordinate: -121.30303
Y Coordinate: 38.69457
Barrier Area: Sidewalks
Barrier Type: Cross Slope - Existing (4.1% to 4.9%)
Code Ref: CBC 1133B.7.1.3 and ADA/ABA 403.3
As Built Meas: 299 Quantity: LF
Description: Cross slope exceeds 2.0% (4.1% to 4.9%)
As Built Desc: 4.4% cross slope
Solution: Demolish existing and construct new route
Bar. Severity: 2 Recommended Cost Estimate: $37,375.00 Status:
Implementation Priority: 4 Facility Function:
Implementation Phase: Implementation Date:
Official Responsible:
Notes:

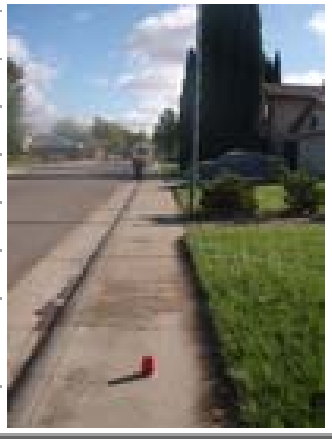
Field Date: 11/10/2010 Report Date: 11/10/2010 Barrier #: 2186

Location: Kaplan Wy - North
X Coordinate: -121.30311
Y Coordinate: 38.69376
Barrier Area: Sidewalks
Barrier Type: Cross Slope - Existing (5.0% or more)
Code Ref: CBC 1133B.7.1 and ADA/ABA 303.3
As Built Meas: 503 Quantity: LF
Description: Cross slope exceeds 2.0% (5.0% or more)
As Built Desc: 5.9% cross slope
Solution: Demolish existing and construct new route
Bar. Severity: 1 Necessary Cost Estimate: $62,875.00 Status:
Implementation Priority: 4 Facility Function:
Implementation Phase: Implementation Date:
Official Responsible:
Notes:

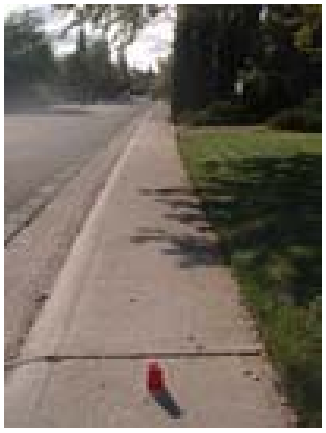
Field Date: 11/10/2010 Report Date: 11/10/2010 Barrier #: 2188

Location: Cassini Wy - West
X Coordinate: -121.30103
Y Coordinate: 38.6936
Barrier Area: Sidewalks
Barrier Type: Cross Slope - Existing (4.1% to 4.9%)
Code Ref: CBC 1133B.7.1.3 and ADA/ABA 403.3
As Built Meas: 159 Quantity: LF
Description: Cross slope exceeds 2.0% (4.1% to 4.9%)
As Built Desc: 4.5% cross slope
Solution: Demolish existing and construct new route
Bar. Severity: 2 Recommended Cost Estimate: $19,875.00 Status:
Implementation Priority: 4 Facility Function:
Implementation Phase: Implementation Date:
Official Responsible:
Notes:

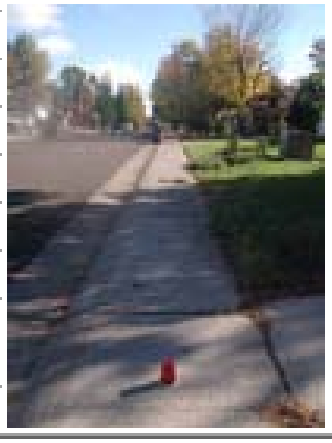
Field Date: 11/10/2010 Report Date: 11/10/2010 Barrier #: 2190

Location: Gimbel Wy - South
X Coordinate: -121.30351
Y Coordinate: 38.69297
Barrier Area: Sidewalks
Barrier Type: Cross Slope - Existing (4.1% to 4.9%)
Code Ref: CBC 1133B.7.1.3 and ADA/ABA 403.3
As Built Meas: 705 Quantity: LF
Description: Cross slope exceeds 2.0% (4.1% to 4.9%)
As Built Desc: 4.7% cross slope
Solution: Demolish existing and construct new route
Bar. Severity: 2 Recommended Cost Estimate: $88,125.00 Status:
Implementation Priority: 4 Facility Function:
Implementation Phase: Implementation Date:
Official Responsible:
Notes:

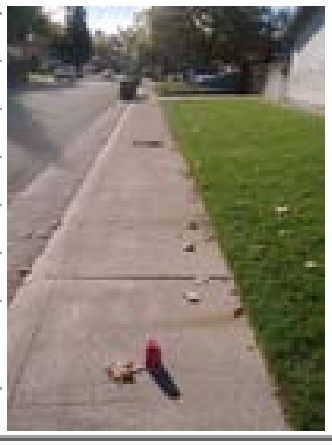
Field Date: 11/10/2010 Report Date: 11/10/2010 Barrier #: 2191

Location: Cassini Wy - West
X Coordinate: -121.30095
Y Coordinate: 38.69293
Barrier Area: Sidewalks
Barrier Type: Cross Slope - Existing (5.0% or more)
Code Ref: CBC 1133B.7.1 and ADA/ABA 303.3
As Built Meas: 311 Quantity: LF
Description: Cross slope exceeds 2.0% (5.0% or more)
As Built Desc: 5.6% cross slope
Solution: Demolish existing and construct new route
Bar. Severity: 1 Necessary Cost Estimate: $38,875.00 Status:
Implementation Priority: 4 Facility Function:
Implementation Phase: Implementation Date:
Official Responsible:
Notes:

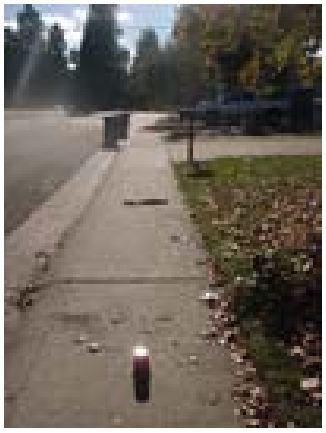
Field Date: 11/10/2010 Report Date: 11/10/2010 Barrier #: 2192

Location: San Tomas Dr - West
X Coordinate: -121.30196
Y Coordinate: 38.69127
Barrier Area: Sidewalks
Barrier Type: Cross Slope - Existing (4.1% to 4.9%)
Code Ref: CBC 1133B.7.1.3 and ADA/ABA 403.3
As Built Meas: 119 Quantity: LF
Description: Cross slope exceeds 2.0% (4.1% to 4.9%)
As Built Desc: 4.6% cross slope
Solution: Demolish existing and construct new route
Bar. Severity: 2 Recommended Cost Estimate: $14,875.00 Status:
Implementation Priority: 4 Facility Function:
Implementation Phase: Implementation Date:
Official Responsible:
Notes:

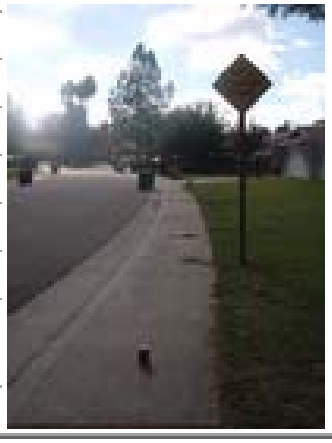
Field Date: 11/10/2010 Report Date: 11/10/2010 Barrier #: 2196

Location: Pippin Wy - West
X Coordinate: -121.30391
Y Coordinate: 38.69137
Barrier Area: Sidewalks
Barrier Type: Cross Slope - Existing (4.1% to 4.9%)
Code Ref: CBC 1133B.7.1.3 and ADA/ABA 403.3
As Built Meas: 150 Quantity: LF
Description: Cross slope exceeds 2.0% (4.1% to 4.9%)
As Built Desc: 4.5% cross slope
Solution: Demolish existing and construct new route
Bar. Severity: 2 Recommended Cost Estimate: $18,750.00 Status:
Implementation Priority: 4 Facility Function:
Implementation Phase: Implementation Date:
Official Responsible:
Notes:

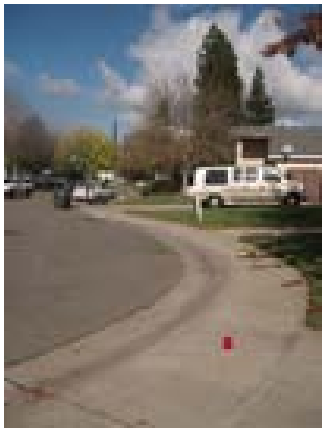
Field Date: 11/10/2010 Report Date: 11/10/2010 Barrier #: 2199A

Location: Ciro Ct - West
X Coordinate: -121.30298
Y Coordinate: 38.69148
Barrier Area: Sidewalks
Barrier Type: Cross Slope - Existing (5.0% or more)
Code Ref: CBC 1133B.7.1 and ADA/ABA 303.3
As Built Meas: 232 Quantity: LF
Description: Cross slope exceeds 2.0% (5.0% or more)
As Built Desc: 5.3% cross slope
Solution: Demolish existing and construct new route
Bar. Severity: 1 Necessary Cost Estimate: $29,000.00 Status:
Implementation Priority: 4 Facility Function:
Implementation Phase: Implementation Date:
Official Responsible:
Notes:

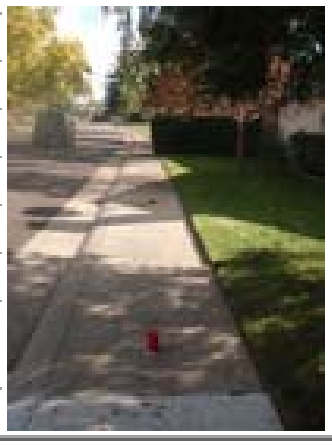
Field Date: 11/10/2010 Report Date: 11/10/2010 Barrier #: 2201

Location: Westchester Wy - South
X Coordinate: -121.30277
Y Coordinate: 38.69154
Barrier Area: Sidewalks
Barrier Type: Cross Slope - Existing (4.1% to 4.9%)
Code Ref: CBC 1133B.7.1.3 and ADA/ABA 403.3
As Built Meas: 176 Quantity: LF
Description: Cross slope exceeds 2.0% (4.1% to 4.9%)
As Built Desc: 4.6% cross slope
Solution: Demolish existing and construct new route
Bar. Severity: 2 Recommended Cost Estimate: $22,000.00 Status:
Implementation Priority: 4 Facility Function:
Implementation Phase: Implementation Date:
Official Responsible:
Notes:

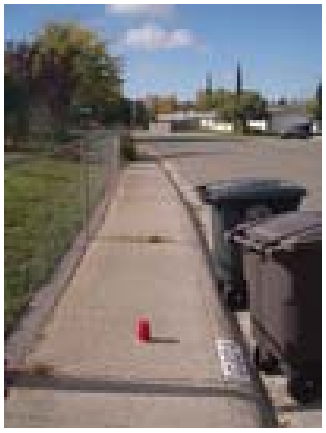
Field Date: 11/10/2010 Report Date: 11/10/2010 Barrier #: 2204A
Location: Winlock Ave - South
X Coordinate: -121.30631
Y Coordinate: 38.69471
Barrier Area: Sidewalks
Barrier Type: Cross Slope - Existing (4.1% to 4.9%)
Code Ref: CBC 1133B.7.1.3 and ADA/ABA 403.3
As Built Meas: 148 Quantity: LF
Description: Cross slope exceeds 2.0% (4.1% to 4.9%)
As Built Desc: 4.5% cross slope
Solution: Demolish existing and construct new route
Bar. Severity: 2 Recommended Cost Estimate: $18,500.00 Status:
Implementation Priority: 4 Facility Function:
Implementation Phase: Implementation Date:
Official Responsible:
Notes:

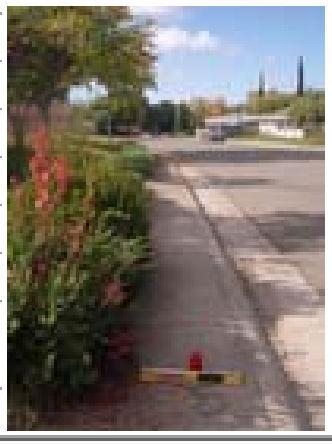
Field Date: 11/10/2010 Report Date: 11/10/2010 Barrier #: 2204B

Location: Winlock Ave - South
X Coordinate: -121.30648
Y Coordinate: 38.69467
Barrier Area: Sidewalks
Barrier Type: Clear Width - Existing (≤31” or less)
Code Ref: CBC 1133B.7.1
As Built Meas: 88 Quantity: LF
Description: Pedestrian route is not min. 48" wide (≤31” or less)
As Built Desc: 31" clear width due to foliage
Solution: Trim foliage to provide min. 48" clear width
Bar. Severity: 1 Necessary Cost Estimate: $0.00 Status:
Implementation Priority: 4 Facility Function:
Implementation Phase: Implementation Date:
Official Responsible:
Notes:

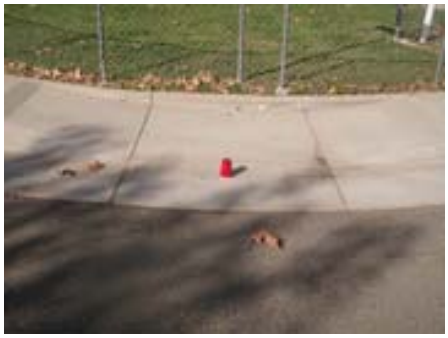
Field Date: 11/10/2010 Report Date: 11/10/2010 Barrier #: 2207
Location: Ansbrough Dr and Tareyton Wy - Corner B
X Coordinate: -121.30665
Y Coordinate: 38.69301
Barrier Area: Curb Ramps
Barrier Type: Detectable Warnings - Truncated Domes
Code Ref: CBC 1127B.5.3 and ADA/ABA 406.2
As Built Meas: 1 Quantity: EACH
Description: No truncated domes provided at curb ramp
As Built Desc: No detectable warnings at curb ramp
Solution: Provide compliant truncated domes
Bar. Severity: 2 Recommended Cost Estimate: $1,400.00 Status:
Implementation Priority: 4 Facility Function:
Implementation Phase: Implementation Date:
Official Responsible:
Notes: Two - way intersection corners A,B

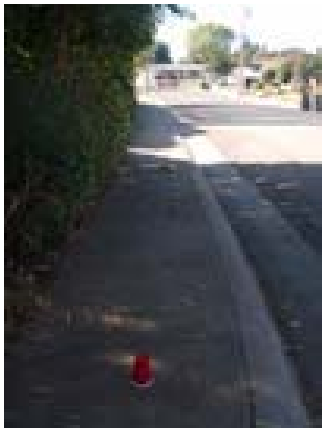
Field Date: 11/10/2010 Report Date: 11/10/2010 Barrier #: 2211A
Location: Tareyton Wy - South
X Coordinate: -121.3069
Y Coordinate: 38.6938
Barrier Area: Sidewalks
Barrier Type: Cross Slope - Existing (5.0% or more)
Code Ref: CBC 1133B.7.1 and ADA/ABA 303.3
As Built Meas: 251 Quantity: LF
Description: Cross slope exceeds 2.0% (5.0% or more)
As Built Desc: 5.4% cross slope
Solution: Demolish existing and construct new route
Bar. Severity: 1 Necessary Cost Estimate: $31,375.00 Status:
Implementation Priority: 4 Facility Function:
Implementation Phase: Implementation Date:
Official Responsible:
Notes:

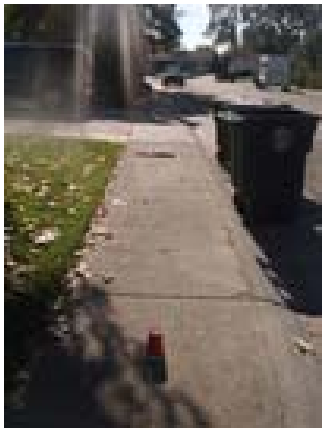
Field Date: 11/10/2010 Report Date: 11/10/2010 Barrier #: 2212
Location: Tareyton Wy - East
X Coordinate: -121.30776
Y Coordinate: 38.69346
Barrier Area: Sidewalks
Barrier Type: Cross Slope - Existing (4.1% to 4.9%)
Code Ref: CBC 1133B.7.1.3 and ADA/ABA 403.3
As Built Meas: 171 Quantity: LF
Description: Cross slope exceeds 2.0% (4.1% to 4.9%)
As Built Desc: 4.7% cross slope
Solution: Demolish existing and construct new route
Bar. Severity: 2 Recommended Cost Estimate: $21,375.00 Status:
Implementation Priority: 4 Facility Function:
Implementation Phase: Implementation Date:
Official Responsible:
Notes:

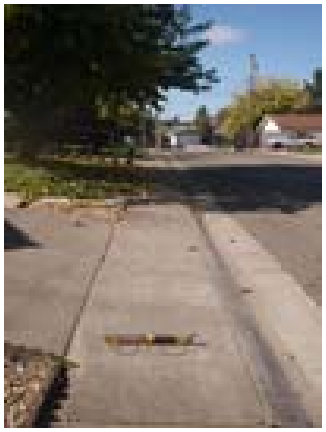
Field Date: 11/10/2010 Report Date: 11/10/2010 Barrier #: 2214A
Location: Tareyton Wy - South
X Coordinate: -121.30676
Y Coordinate: 38.69293
Barrier Area: Sidewalks
Barrier Type: Cross Slope - Existing (4.1% to 4.9%)
Code Ref: CBC 1133B.7.1.3 and ADA/ABA 403.3
As Built Meas: 265 Quantity: LF
Description: Cross slope exceeds 2.0% (4.1% to 4.9%)
As Built Desc: 4.6% cross slope
Solution: Demolish existing and construct new route
Bar. Severity: 2 Recommended Cost Estimate: $33,125.00 Status:
Implementation Priority: 4 Facility Function:
Implementation Phase: Implementation Date:
Official Responsible:
Notes:

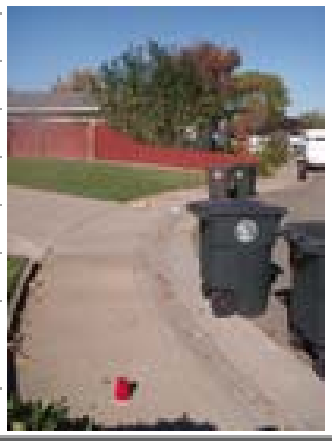
Field Date: 11/10/2010 Report Date: 11/10/2010 Barrier #: 2215

Location: Tareyton Wy - West
X Coordinate: -121.30792
Y Coordinate: 38.6934
Barrier Area: Sidewalks
Barrier Type: Cross Slope - Existing (5.0% or more)
Code Ref: CBC 1133B.7.1 and ADA/ABA 303.3
As Built Meas: 247 Quantity: LF
Description: Cross slope exceeds 2.0% (5.0% or more)
As Built Desc: 5.2% cross slope
Solution: Demolish existing and construct new route
Bar. Severity: 1 Necessary Cost Estimate: $30,875.00 Status:
Implementation Priority: 4 Facility Function:
Implementation Phase: Implementation Date:
Official Responsible:
Notes:

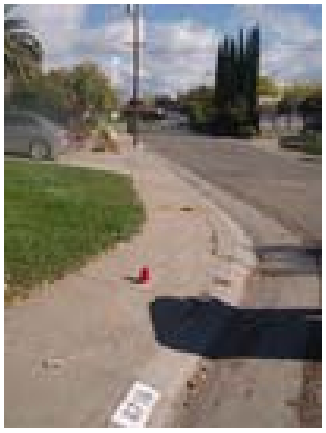
Field Date: 11/10/2010 Report Date: 11/10/2010 Barrier #: 2216A

Location: Tareyton Wy - North
X Coordinate: -121.3077
Y Coordinate: 38.69364
Barrier Area: Sidewalks
Barrier Type: Cross Slope - Existing (5.0% or more)
Code Ref: CBC 1133B.7.1 and ADA/ABA 303.3
As Built Meas: 325 Quantity: LF
Description: Cross slope exceeds 2.0% (5.0% or more)
As Built Desc: 5.9% cross slope
Solution: Demolish existing and construct new route
Bar. Severity: 1 Necessary Cost Estimate: $40,625.00 Status:
Implementation Priority: 4 Facility Function:
Implementation Phase: Implementation Date:
Official Responsible:
Notes:

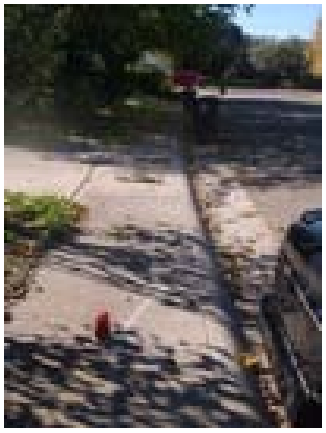
Field Date: 11/10/2010 Report Date: 11/10/2010 Barrier #: 2217
Location: Winlock Ave - South
X Coordinate: -121.30774
Y Coordinate: 38.69424
Barrier Area: Sidewalks
Barrier Type: Cross Slope - Existing (4.1% to 4.9%)
Code Ref: CBC 1133B.7.1.3 and ADA/ABA 403.3
As Built Meas: 89 Quantity: LF
Description: Cross slope exceeds 2.0% (4.1% to 4.9%)
As Built Desc: 4.6% cross slope
Solution: Demolish existing and construct new route
Bar. Severity: 2 Recommended Cost Estimate: $11,125.00 Status:
Implementation Priority: 4 Facility Function:
Implementation Phase: Implementation Date:
Official Responsible:
Notes:

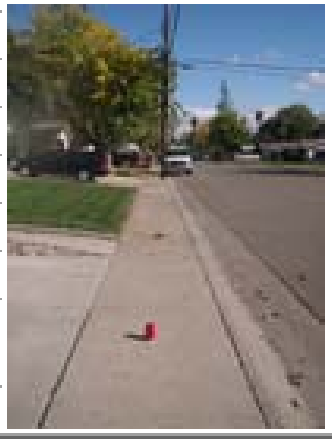
Field Date: 11/10/2010 Report Date: 11/10/2010 Barrier #: 2221A

Location: Kittery Ave - North
X Coordinate: -121.30864
Y Coordinate: 38.69226
Barrier Area: Sidewalks
Barrier Type: Cross Slope - Existing (5.0% or more)
Code Ref: CBC 1133B.7.1 and ADA/ABA 303.3
As Built Meas: 389 Quantity: LF
Description: Cross slope exceeds 2.0% (5.0% or more)
As Built Desc: 5.8% cross slope
Solution: Demolish existing and construct new route
Bar. Severity: 1 Necessary Cost Estimate: $48,625.00 Status:
Implementation Priority: 4 Facility Function:
Implementation Phase: Implementation Date:
Official Responsible:
Notes:

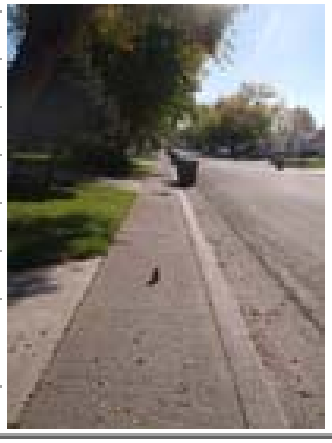
Field Date: 11/10/2010 Report Date: 11/10/2010 Barrier #: 2225A

Location: Falworth St - East
X Coordinate: -121.30782
Y Coordinate: 38.69211
Barrier Area: Sidewalks
Barrier Type: Cross Slope - Existing (5.0% or more)
Code Ref: CBC 1133B.7.1 and ADA/ABA 303.3
As Built Meas: 392 Quantity: LF
Description: Cross slope exceeds 2.0% (5.0% or more)
As Built Desc: 6.7% cross slope
Solution: Demolish existing and construct new route
Bar. Severity: 1 Necessary Cost Estimate: $49,000.00 Status:
Implementation Priority: 4 Facility Function:
Implementation Phase: Implementation Date:
Official Responsible:
Notes:

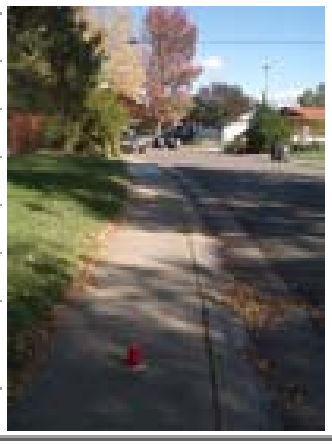
Field Date: 11/10/2010 Report Date: 11/10/2010 Barrier #: 2228

Location: Coventry Dr - North
X Coordinate: -121.30764
Y Coordinate: 38.69096
Barrier Area: Sidewalks
Barrier Type: Cross Slope - Existing (5.0% or more)
Code Ref: CBC 1133B.7.1 and ADA/ABA 303.3
As Built Meas: 106 Quantity: LF
Description: Cross slope exceeds 2.0% (5.0% or more)
As Built Desc: 5.0% cross slope
Solution: Demolish existing and construct new route
Bar. Severity: 1 Necessary Cost Estimate: $13,250.00 Status:
Implementation Priority: 4 Facility Function:
Implementation Phase: Implementation Date:
Official Responsible:
Notes:

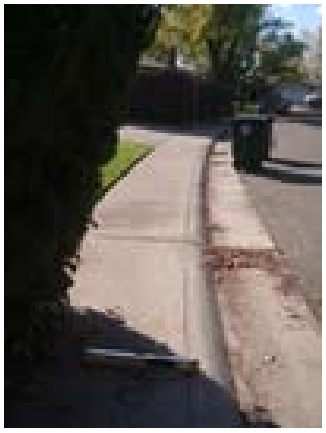
Field Date: 11/10/2010 Report Date: 11/10/2010 Barrier #: 2234B

Location: Coventry Dr - East
X Coordinate: -121.30695
Y Coordinate: 38.69129
Barrier Area: Sidewalks
Barrier Type: Clear Width - Existing (≤31” or less)
Code Ref: CBC 1133B.7.1
As Built Meas: 6 Quantity: LF
Description: Pedestrian route is not min. 48" wide (≤31” or less)
As Built Desc: 28" clear width due to foliage
Solution: Trim foliage to provide min. 48" clear width
Bar. Severity: 1 Necessary Cost Estimate: $0.00 Status:
Implementation Priority: 4 Facility Function:
Implementation Phase: Implementation Date:
Official Responsible:
Notes:

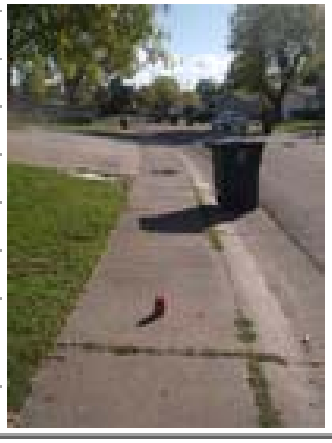
Field Date: 11/10/2010 Report Date: 11/10/2010 Barrier #: 2240

Location: Falworth St - East
X Coordinate: -121.30778
Y Coordinate: 38.68994
Barrier Area: Sidewalks
Barrier Type: Cross Slope - Existing (5.0% or more)
Code Ref: CBC 1133B.7.1 and ADA/ABA 303.3
As Built Meas: 279 Quantity: LF
Description: Cross slope exceeds 2.0% (5.0% or more)
As Built Desc: 5.2% cross slope
Solution: Demolish existing and construct new route
Bar. Severity: 1 Necessary Cost Estimate: $34,875.00 Status:
Implementation Priority: 4 Facility Function:
Implementation Phase: Implementation Date:
Official Responsible:
Notes:

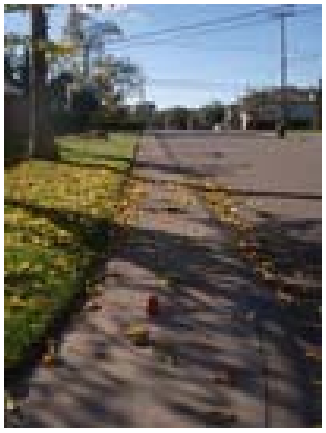
Field Date: 11/10/2010 Report Date: 11/10/2010 Barrier #: 2242

Location: Kittery Ave - South
X Coordinate: -121.30797
Y Coordinate: 38.69212
Barrier Area: Sidewalks
Barrier Type: Cross Slope - Existing (5.0% or more)
Code Ref: CBC 1133B.7.1 and ADA/ABA 303.3
As Built Meas: 185 Quantity: LF
Description: Cross slope exceeds 2.0% (5.0% or more)
As Built Desc: 5.1% cross slope
Solution: Demolish existing and construct new route
Bar. Severity: 1 Necessary Cost Estimate: $23,125.00 Status:
Implementation Priority: 4 Facility Function:
Implementation Phase: Implementation Date:
Official Responsible:
Notes:

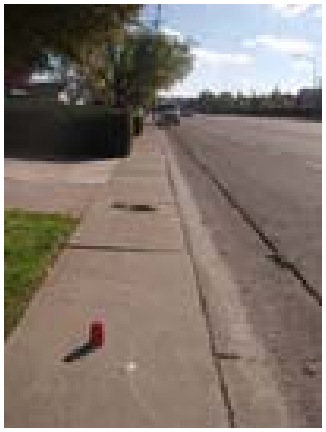
Field Date: 11/10/2010 Report Date: 11/10/2010 Barrier #: 2243
Location: Van Maren Ln - East
X Coordinate: -121.30867
Y Coordinate: 38.69206
Barrier Area: Sidewalks
Barrier Type: Clear Width - Existing (32” to 35”)
Code Ref: CBC 1133B.7.1
As Built Meas: 4 Quantity: LF
Description: Pedestrian route is not min. 48" wide (32” to 35”)
As Built Desc: 32" clear width due to pole
Solution: Demolish existing and construct new route
Bar. Severity: 2 Recommended Cost Estimate: $500.00 Status:
Implementation Priority: 1 Facility Function:
Implementation Phase: Implementation Date:
Official Responsible:
Notes:

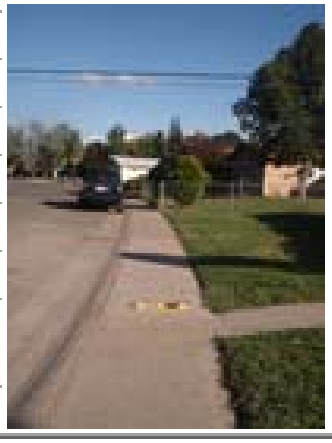
Field Date: 11/10/2010 Report Date: 11/10/2010 Barrier #: 2245

Location: Somersworth Dr - South
X Coordinate: -121.30848
Y Coordinate: 38.68864
Barrier Area: Sidewalks
Barrier Type: Cross Slope - Existing (5.0% or more)
Code Ref: CBC 1133B.7.1 and ADA/ABA 303.3
As Built Meas: 715 Quantity: LF
Description: Cross slope exceeds 2.0% (5.0% or more)
As Built Desc: 7.8% cross slope
Solution: Demolish existing and construct new route
Bar. Severity: 1 Necessary Cost Estimate: $89,375.00 Status:
Implementation Priority: 4 Facility Function:
Implementation Phase: Implementation Date:
Official Responsible:
Notes:

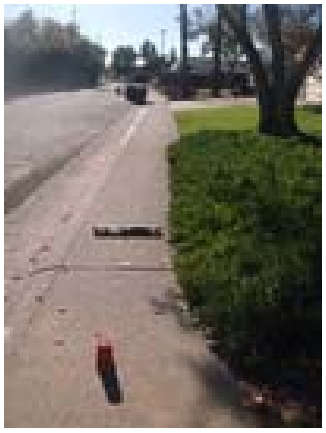
Field Date: 11/10/2010 Report Date: 11/10/2010 Barrier #: 2246

Location: Janet Dr - West
X Coordinate: -121.30645
Y Coordinate: 38.68967
Barrier Area: Sidewalks
Barrier Type: Cross Slope - Existing (5.0% or more)
Code Ref: CBC 1133B.7.1 and ADA/ABA 303.3
As Built Meas: 260 Quantity: LF
Description: Cross slope exceeds 2.0% (5.0% or more)
As Built Desc: 5.9% cross slope
Solution: Demolish existing and construct new route
Bar. Severity: 1 Necessary Cost Estimate: $32,500.00 Status:
Implementation Priority: 4 Facility Function:
Implementation Phase: Implementation Date:
Official Responsible:
Notes:

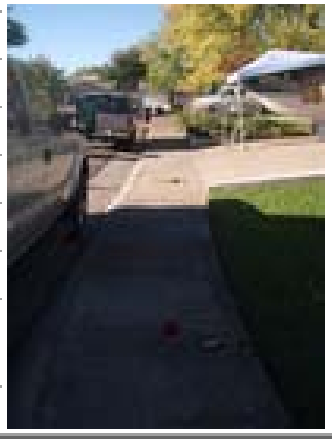
Field Date: 11/10/2010 Report Date: 11/10/2010 Barrier #: 2249

Location: Janet Dr - East
X Coordinate: -121.30582
Y Coordinate: 38.68943
Barrier Area: Sidewalks
Barrier Type: Cross Slope - Existing (4.1% to 4.9%)
Code Ref: CBC 1133B.7.1.3 and ADA/ABA 403.3
As Built Meas: 120 Quantity: LF
Description: Cross slope exceeds 2.0% (4.1% to 4.9%)
As Built Desc: 4.2% cross slope
Solution: Demolish existing and construct new route
Bar. Severity: 2 Recommended Cost Estimate: $15,000.00 Status:
Implementation Priority: 4 Facility Function:
Implementation Phase: Implementation Date:
Official Responsible:
Notes:

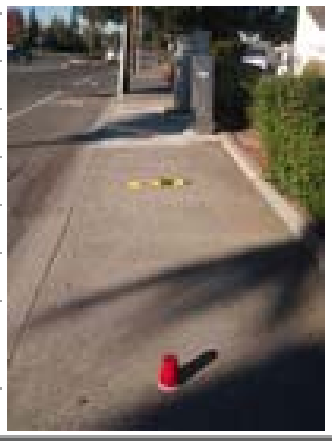
Field Date: 11/10/2010 Report Date: 11/10/2010 Barrier #: 2251

Location: Van Maren Ln - East
X Coordinate: -121.30862
Y Coordinate: 38.68863
Barrier Area: Sidewalks
Barrier Type: Cross Slope - Existing (5.0% or more)
Code Ref: CBC 1133B.7.1 and ADA/ABA 303.3
As Built Meas: 384 Quantity: LF
Description: Cross slope exceeds 2.0% (5.0% or more)
As Built Desc: 7.3% cross slope
Solution: Demolish existing and construct new route
Bar. Severity: 1 Necessary Cost Estimate: $48,000.00 Status:
Implementation Priority: 1 Facility Function:
Implementation Phase: Implementation Date:
Official Responsible:
Notes:

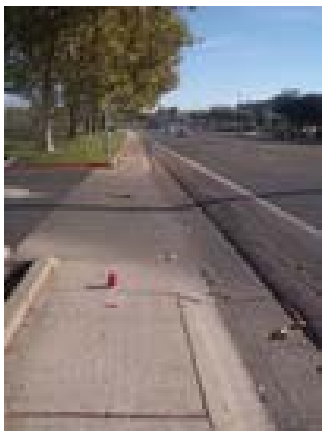
Field Date: 11/11/2010 Report Date: 11/11/2010 Barrier #: 2255

Location: Auburn Blvd - North
X Coordinate: -121.29324
Y Coordinate: 38.69377
Barrier Area: Sidewalks
Barrier Type: Driveway - Existing (5.0% or more)
Code Ref: CBC 1133B.7.1.3 and ADA/ABA 403.3
As Built Meas: 48 Quantity: LF
Description: Driveway cross slope exceeds 2.0% (5.0% or more)
As Built Desc: 6.8% cross slope, 11.6% running slope
Solution: Provide min. 48" wide level walkway through driveway
Bar. Severity: 1 Necessary Cost Estimate: $6,000.00 Status:
Implementation Priority: 1 Facility Function:
Implementation Phase: Implementation Date:
Official Responsible:
Notes:

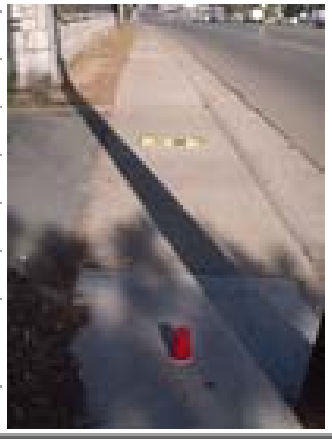
Field Date: 11/11/2010 Report Date: 11/11/2010 Barrier #: 2271

Location: Auburn Blvd - West
X Coordinate: -121.29046
Y Coordinate: 38.69878
Barrier Area: Sidewalks
Barrier Type: Driveway - Existing (5.0% or more)
Code Ref: CBC 1133B.7.1.3 and ADA/ABA 403.3
As Built Meas: 20 Quantity: LF
Description: Driveway cross slope exceeds 2.0% (5.0% or more)
As Built Desc: 7.1% cross slope
Solution: Provide min. 48" wide level walkway through driveway
Bar. Severity: 4 Low Severity Cost Estimate: $2,500.00 Status:
Implementation Priority: 1 Facility Function:
Implementation Phase: Implementation Date:
Official Responsible:
Notes:

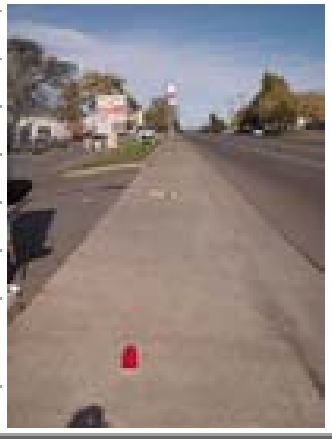
Field Date: 11/11/2010 Report Date: 11/11/2010 Barrier #: 2279

Location: Auburn Blvd - West
X Coordinate: -121.29048
Y Coordinate: 38.70224
Barrier Area: Sidewalks
Barrier Type: Driveway - Existing (5.0% or more)
Code Ref: CBC 1133B.7.1.3 and ADA/ABA 403.3
As Built Meas: 47 Quantity: LF
Description: Driveway cross slope exceeds 2.0% (5.0% or more)
As Built Desc: 10.7% cross slope, 9.3% running slope
Solution: Provide min. 48" wide level walkway through driveway
Bar. Severity: 1 Necessary Cost Estimate: $5,875.00 Status:
Implementation Priority: 1 Facility Function:
Implementation Phase: Implementation Date:
Official Responsible:
Notes:

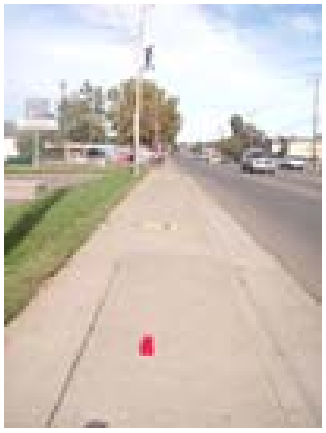
Field Date: 11/11/2010 Report Date: 11/11/2010 Barrier #: 2286

Location: Auburn Blvd - West
X Coordinate: -121.29055
Y Coordinate: 38.70416
Barrier Area: Sidewalks
Barrier Type: Cross Slope - Existing (3.1% to 4.0%)
Code Ref: CBC 1133B.7.1.3 and ADA/ABA 403.3
As Built Meas: 123 Quantity: LF
Description: Cross slope exceeds 2.0% (3.1% to 4.0%)
As Built Desc: 3.3% cross slope
Solution: Demolish existing and construct new route
Bar. Severity: 3 Hinderance Cost Estimate: $15,375.00 Status:
Implementation Priority: 1 Facility Function:
Implementation Phase: Implementation Date:
Official Responsible:
Notes:

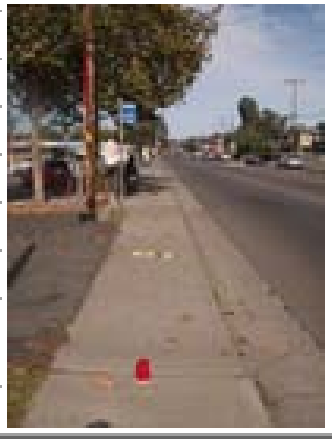
Field Date: 11/11/2010 Report Date: 11/11/2010 Barrier #: 2288

Location: Auburn Blvd - West
X Coordinate: -121.2905
Y Coordinate: 38.70443
Barrier Area: Sidewalks
Barrier Type: Driveway - Existing (4.1% to 4.9%)
Code Ref: CBC 1133B.7.1.3 and ADA/ABA 403.3
As Built Meas: 22 Quantity: LF
Description: Driveway cross slope exceeds 2.0% (4.1% to 4.9%)
As Built Desc: 4.8% cross slope, 17.0% running slope
Solution: Provide min. 48" wide level walkway through driveway
Bar. Severity: 1 Necessary Cost Estimate: $2,750.00 Status:
Implementation Priority: 1 Facility Function:
Implementation Phase: Implementation Date:
Official Responsible:
Notes:

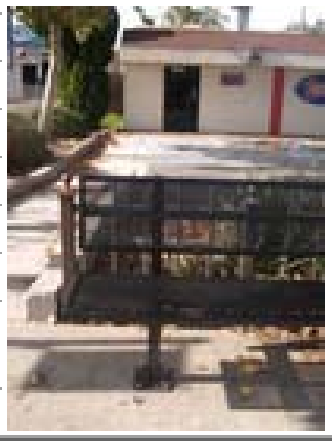
Field Date: 11/11/2010 Report Date: 11/11/2010 Barrier #: 2289A

Location: Auburn Blvd - West
X Coordinate: -121.29052
Y Coordinate: 38.70454
Barrier Area: Bus Stops and Shelters
Barrier Type: Bench Seat Depth
Code Ref: ADAAG 4.37.4 and ADA/ABA 903.4
As Built Meas: 1 Quantity: EACH
Description: Bench seat depth not 20" - 24" deep
As Built Desc: 17" bench seat depth
Solution: Provide min. 1 accessible bench at bench stop
Bar. Severity: 3 Hindrance Cost Estimate: $775.00 Status:
Implementation Priority: 1 Facility Function:
Implementation Phase: Implementation Date:
Official Responsible:
Notes:

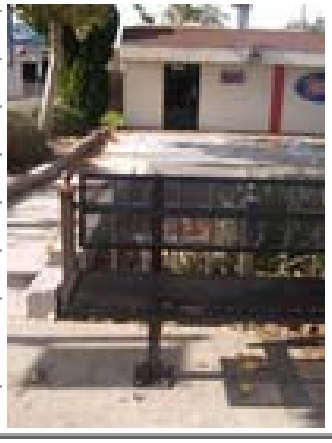
Field Date: 11/11/2010 Report Date: 11/11/2010 Barrier #: 2289B

Location: Auburn Blvd - West
X Coordinate: -121.29052
Y Coordinate: 38.70454
Barrier Area: Bus Stops and Shelters
Barrier Type: Bench Back Support
Code Ref: ADAAG 4.37.4 and ADA/ABA 903.4
As Built Meas: 1 Quantity: EACH
Description: Back support does not extend from 2" above seat to min. 18" above seat
As Built Desc: 16" back support height
Solution: Provide min. 1 accessible bench at bench stop or shelter
Bar. Severity: 3 Hindrance Cost Estimate: $0.00 Status:
Implementation Priority: 1 Facility Function:
Implementation Phase: Implementation Date:
Official Responsible:
Notes:

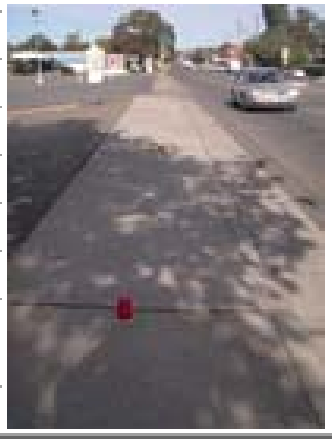
Field Date: 11/11/2010 Report Date: 11/11/2010 Barrier #: 2290

Location: Auburn Blvd - West
X Coordinate: -121.29053
Y Coordinate: 38.70461
Barrier Area: Sidewalks
Barrier Type: Driveway - Existing (4.1% to 4.9%)
Code Ref: CBC 1133B.7.1.3 and ADA/ABA 403.3
As Built Meas: 53 Quantity: LF
Description: Driveway cross slope exceeds 2.0% (4.1% to 4.9%)
As Built Desc: 4.5% cross slope
Solution: Provide min. 48" wide level walkway through driveway
Bar. Severity: 3 Hinderance Cost Estimate: $6,625.00 Status:
Implementation Priority: 1 Facility Function:
Implementation Phase: Implementation Date:
Official Responsible:
Notes:

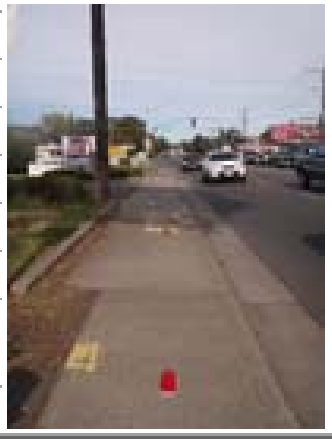
Field Date: 11/11/2010 Report Date: 11/11/2010 Barrier #: 2296

Location: Auburn Blvd - West
X Coordinate: -121.29054
Y Coordinate: 38.70578
Barrier Area: Sidewalks
Barrier Type: Cross Slope - Existing (4.1% to 4.9%)
Code Ref: CBC 1133B.7.1.3 and ADA/ABA 403.3
As Built Meas: 49 Quantity: LF
Description: Cross slope exceeds 2.0% (4.1% to 4.9%)
As Built Desc: 4.1% cross slope
Solution: Demolish existing and construct new route
Bar. Severity: 2 Recommended Cost Estimate: $6,125.00 Status:
Implementation Priority: 1 Facility Function:
Implementation Phase: Implementation Date:
Official Responsible:
Notes:

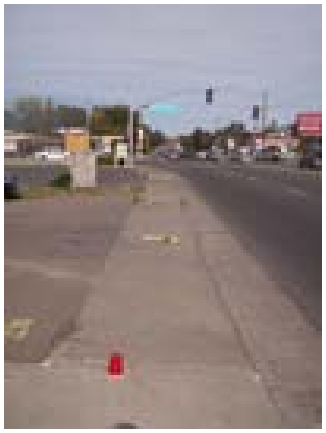
Field Date: 11/11/2010 Report Date: 11/11/2010 Barrier #: 2298

Location: Auburn Blvd - West
X Coordinate: -121.29054
Y Coordinate: 38.70608
Barrier Area: Sidewalks
Barrier Type: Driveway - Existing (4.1% to 4.9%)
Code Ref: CBC 1133B.7.1.3 and ADA/ABA 403.3
As Built Meas: 39 Quantity: LF
Description: Driveway cross slope exceeds 2.0% (4.1% to 4.9%)
As Built Desc: 4.2% cross slope, 17.2% running slope
Solution: Provide min. 48" wide level walkway through driveway
Bar. Severity: 1 Necessary Cost Estimate: $4,875.00 Status:
Implementation Priority: 1 Facility Function:
Implementation Phase: Implementation Date:
Official Responsible:
Notes:

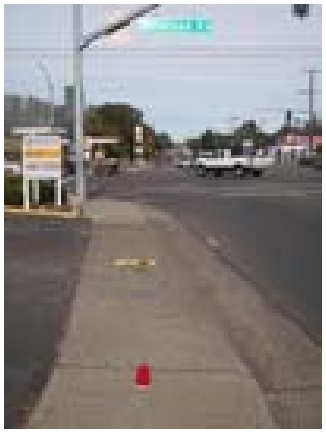
Field Date: 11/11/2010 Report Date: 11/11/2010 Barrier #: 2299

Location: Auburn Blvd - West
X Coordinate: -121.29053
Y Coordinate: 38.70622
Barrier Area: Sidewalks
Barrier Type: Driveway - Existing (5.0% or more)
Code Ref: CBC 1133B.7.1.3 and ADA/ABA 403.3
As Built Meas: 22 Quantity: LF
Description: Driveway cross slope exceeds 2.0% (5.0% or more)
As Built Desc: 5.1% cross slope, 10.5% running slope
Solution: Provide min. 48" wide level walkway through driveway
Bar. Severity: 1 Necessary Cost Estimate: $2,750.00 Status:
Implementation Priority: 1 Facility Function:
Implementation Phase: Implementation Date:
Official Responsible:
Notes:
