CITY OF CITRUS HEIGHTS

DRAFT ADA TRANSITION PLAN UPDATE

NEIGHBORHOOD AREA 6 SUNRISE RANCH

SEPTEMBER 20, 2011

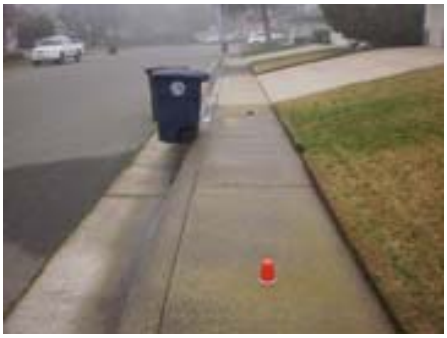
Field Date: 1/26/2011 Report Date: 1/26/2011 Barrier #: 4548C
Location: Cottingham Wy and Heredia Ct - Corner A
X Coordinate: -121.28011
Y Coordinate: 38.70305
Barrier Area: Curb Ramps
Barrier Type: Parallel Ramp Landing - Existing (>5.0% or more)
Code Ref: CBC 1127B.5.4 and ADA/ABA 406.4
As Built Meas: 1 Quantity: EACH
Description: Curb ramp landing or pan not level (>5.0% or more)
As Built Desc: 6.9% landing slope
Solution: Demolish existing and construct new transition
Bar. Severity: 1 Necessary Cost Estimate: $0.00 Status:
Implementation Priority: 4 Facility Function:
Implementation Phase: Implementation Date:
Official Responsible:
Notes: Three - way intersection corners A,B,D

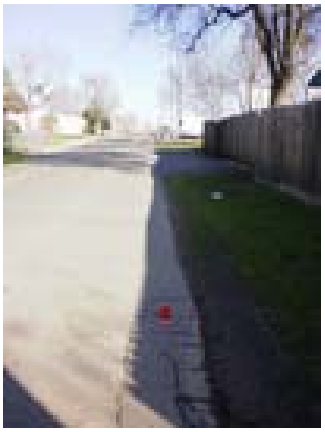
Field Date: 2/1/2011 Report Date: 2/3/2011 Barrier #: 4783
Location: Patton Ave - West
X Coordinate: -121.27657
Y Coordinate: 38.70806
Barrier Area: Sidewalks
Barrier Type: No Sidewalk - No Barricade
Code Ref: MUTCD Section 6D.01
As Built Meas: 1 Quantity: JOB
Description: No barricade provided where sidewalk ends in hazardous location
As Built Desc: No barricade or other warning provided for the visually impaired at end of sidewalk
Solution: Provide barricade with cane detectable warning at end of sidewalk
Bar. Severity: 1 Necessary Cost Estimate: $1,350.00 Status:
Implementation Priority: 3 Facility Function:
Implementation Phase: Implementation Date:
Official Responsible:
Notes:

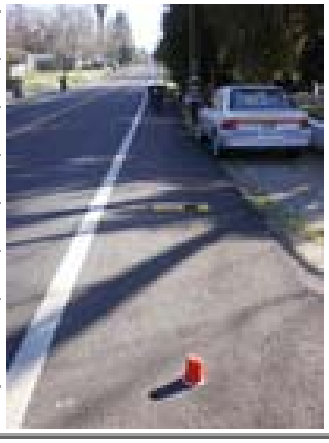
Field Date: 2/2/2011 Report Date: 2/3/2011 Barrier #: 4801

Location: Twin Oaks Ave - South
X Coordinate: -121.2762
Y Coordinate: 38.71851
Barrier Area: Sidewalks
Barrier Type: Shoulder Cross Slope - Existing (3.1% to 4.0%)
Code Ref: CBC 1133B.7.1.3 and ADA/ABA 403.3
As Built Meas: 240 Quantity: LF
Description: Cross slope exceeds 2.0% (3.1% to 4.0%)
As Built Desc: 3.9% cross slope
Solution: Demolish existing and construct new pedestrian route
Bar. Severity: 3 Hinderance Cost Estimate: $30,000.00 Status:
Implementation Priority: 3 Facility Function:
Implementation Phase: Implementation Date:
Official Responsible:
Notes:

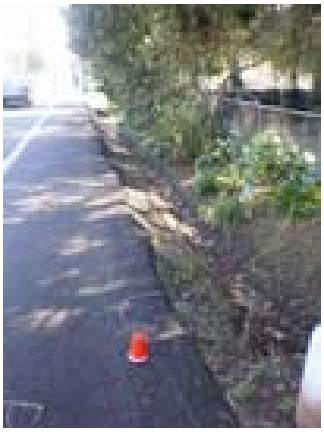
Field Date: 2/2/2011 Report Date: 2/3/2011 Barrier #: 4802

Location: Twin Oaks Ave - South
X Coordinate: -121.27602
Y Coordinate: 38.71853
Barrier Area: Sidewalks
Barrier Type: Drop-off Along Ped Route (> 4")
Code Ref: CBC 1133B.8.1
As Built Meas: 220 Quantity: LF
Description: Drop of more than 4" along pedestrian route lacks warning curb
As Built Desc: 12" drop off creates hazardous condition for the visually impaired
Solution: Provide curb projecting at least 6" above the walk or sidewalk surface to warn the blind of a potent
Bar. Severity: 1 Necessary Cost Estimate: $38,500.00 Status:
Implementation Priority: 3 Facility Function:
Implementation Phase: Implementation Date:
Official Responsible:
Notes:

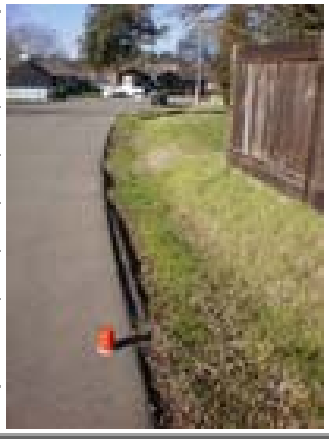
Field Date: 2/2/2011 Report Date: 2/3/2011 Barrier #: 4808
Location: Dracena Dr - North
X Coordinate: -121.27429
Y Coordinate: 38.71436
Barrier Area: Sidewalks
Barrier Type: No sidewalk
Code Ref: CBC 1127B.1 and ADA/ABA 206.2.1
As Built Meas: 379 Quantity: LF
Description: No pedestrian route provided
As Built Desc: No sidewalk provided
Solution: Construct new firm and stable pedestrian route
Bar. Severity: 1 Necessary Cost Estimate: $37,900.00 Status:
Implementation Priority: 4 Facility Function:
Implementation Phase: Implementation Date:
Official Responsible:
Notes:

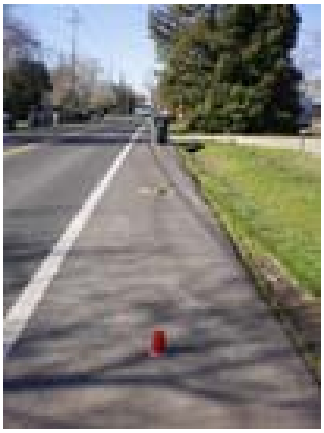
Field Date: 2/2/2011 Report Date: 2/3/2011 Barrier #: 4818
Location: Victory Wy - West
X Coordinate: -121.27385
Y Coordinate: 38.7203
Barrier Area: Sidewalks
Barrier Type: No sidewalk
Code Ref: CBC 1127B.1 and ADA/ABA 206.2.1
As Built Meas: 615 Quantity: LF
Description: No pedestrian route provided
As Built Desc: No sidewalk provided
Solution: Construct new firm and stable pedestrian route
Bar. Severity: 1 Necessary Cost Estimate: $61,500.00 Status:
Implementation Priority: 4 Facility Function:
Implementation Phase: Implementation Date:
Official Responsible:
Notes:

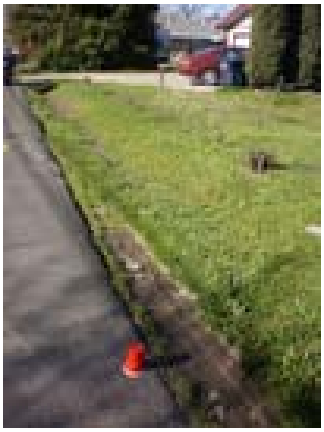
Field Date: 2/2/2011 Report Date: 2/3/2011 Barrier #: 4819A
Location: Twin Oaks Ave - North
X Coordinate: -121.27395
Y Coordinate: 38.71865
Barrier Area: Sidewalks
Barrier Type: Shoulder Cross Slope - Existing (4.1% to 4.9%)
Code Ref: CBC 1133B.7.1.3 and ADA/ABA 403.3
As Built Meas: 182 Quantity: LF
Description: Cross slope exceeds 2.0% (4.1% to 4.9%)
As Built Desc: 4.4% cross slope
Solution: Demolish existing and construct new pedestrian route
Bar. Severity: 2 Recommended Cost Estimate: $22,750.00 Status:
Implementation Priority: 3 Facility Function:
Implementation Phase: Implementation Date:
Official Responsible:
Notes:
