DRAFT ADA TRANSITION PLAN UPDATE
NEIGHBORHOOD AREA 1 NORTHWEST
SEPTEMBER 20, 2011

CITY OF CITRUS HEIGHTS

The Northwest Neighborhood Association

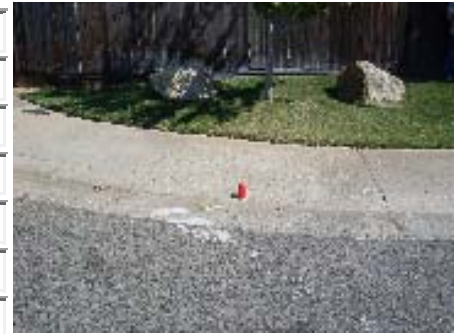
Barrier Type: No Curb Ramp - Depressed Existing Curb

Code Ref: CBC 1127B.5.1 and ADA/ABA 402.2

As Built Meas: 1 Quantity: EACH

Description: No compliant curb cut at corner (intersection)

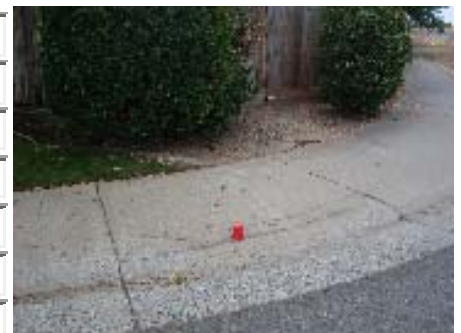
Barrier Type: No Curb Ramp - Depressed Existing Curb

Code Ref: CBC 1127B.5.1 and ADA/ABA 402.2

As Built Meas: 1 Quantity: EACH

Description: No compliant curb cut at corner (intersection)

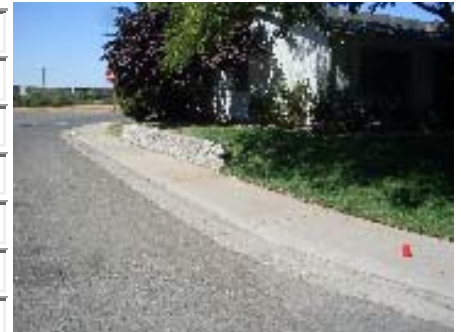
Barrier Type: Cross Slope - New Construction

Code Ref: CBC 1133B.7.1.3 and ADA/ABA 403.3

As Built Meas: 84 Quantity: LF

Description: Cross slope exceeds 2.0% in new construction

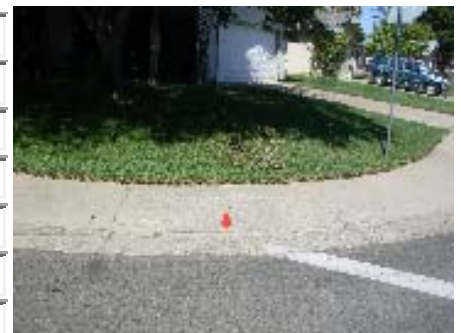
Barrier Type: No Curb Ramp - Depressed Existing Curb

Code Ref: CBC 1127B.5.1 and ADA/ABA 402.2

As Built Meas: 1 Quantity: EACH

Description: No compliant curb cut at corner (intersection)

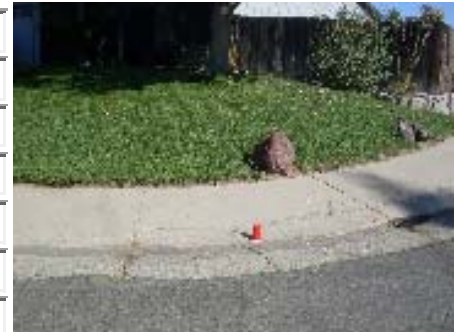
Barrier Type: No Curb Ramp - Depressed Existing Curb

Code Ref: CBC 1127B.5.1 and ADA/ABA 402.2

As Built Meas: 1 Quantity: EACH

Description: No compliant curb cut at corner (intersection)

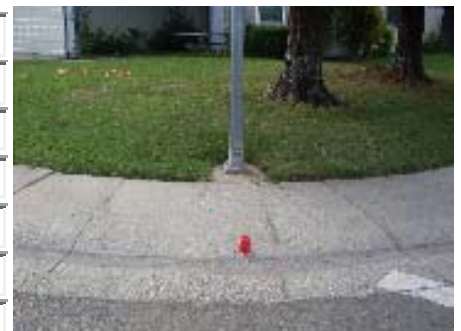
Barrier Type: No Curb Ramp - Depressed Existing Curb

Code Ref: CBC 1127B.5.1 and ADA/ABA 402.2

As Built Meas: 1 Quantity: EACH

Description: No compliant curb cut at corner (intersection)

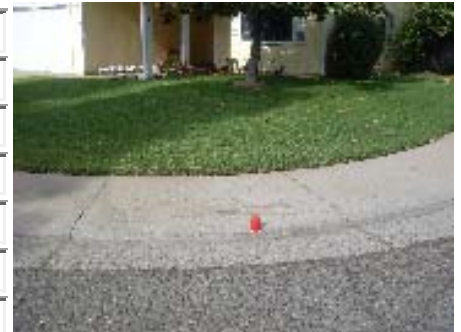
Barrier Type: No Curb Ramp - Depressed Existing Curb

Code Ref: CBC 1127B.5.1 and ADA/ABA 402.2

As Built Meas: 1 Quantity: EACH

Description: No compliant curb cut at corner (intersection)

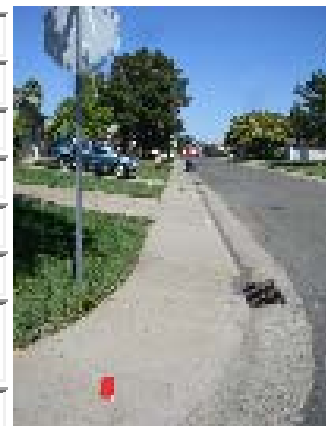
Barrier Type: Cross Slope - New Construction

Code Ref: CBC 1133B.7.1.3 and ADA/ABA 403.3

As Built Meas: 352 Quantity: LF

Description: Cross slope exceeds 2.0% in new construction

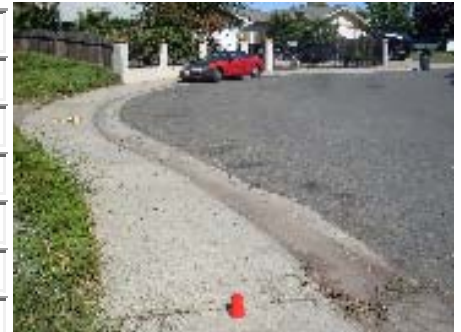
Barrier Type: Cross Slope - New Construction

Code Ref: CBC 1133B.7.1.3 and ADA/ABA 403.3

As Built Meas: 126 Quantity: LF

Description: Cross slope exceeds 2.0% in new construction

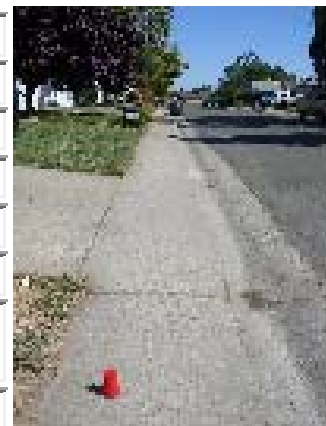
Barrier Type: Cross Slope - Existing (5.0% or more)

Code Ref: CBC 1133B.7.1.3 and ADA/ABA 403.3

As Built Meas: 289 Quantity: LF

Description: Cross slope exceeds 2.0% (5.0% or more)

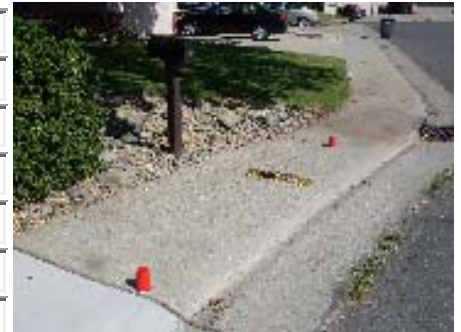
Barrier Type: Cross Slope - Existing (2.1% to 3.0%)

Code Ref: CBC 1133B.7.1.3 and ADA/ABA 403.3

As Built Meas: 12 Quantity: LF

Description: Cross slope exceeds 2.0% (2.1% to 3.0%)

Solution: Low severity barrier - no remediation recommended

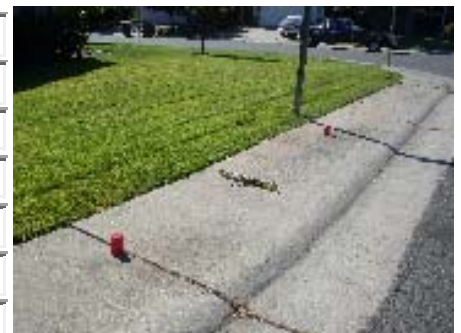
Barrier Type: Cross Slope - Existing (3.1% to 4.0%)

Code Ref: CBC 1133B.7.1.3 and ADA/ABA 403.3

As Built Meas: 10 Quantity: LF

Description: Cross slope exceeds 2.0% (3.1% to 4.0%)

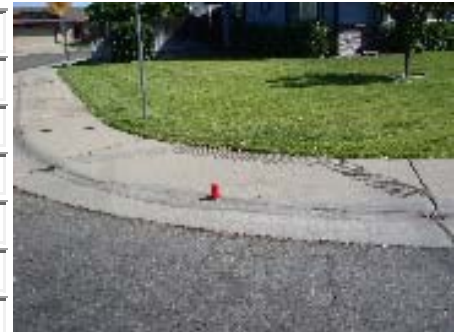
Field Date:	9/28/2010	Report Date:	9/28/2010	Barrier #:	13A
Location:	Julie Lynn Ct and Imran Woods Cir - Corner C				
X Coordinate:	-121.30697				
Y Coordinate:	38.72230				
Barrier Area:	Curb Ramps				
Barrier Type:	12" Grooves - Existing (4.1% to 4.9%)				
Code Ref:	CBC 1127B.5.6

As Built Meas:	1	Quantity:	EACH
Description:	12" grooves at top of curb ramp are not level (4.1% to 4.9%)		
As Built Desc:	4.2% at 12" grooves		
Solution:	Demolish existing and construct new curb ramp		
Bar. Severity:	2 Recommended	Cost Estimate:	\$2,500.00
Implementation Priority:	4	Facility Function:	
Implementation Phase:		Implementation Date:	
Official Responsible:			
Notes:	Two - way intersection corners C,D

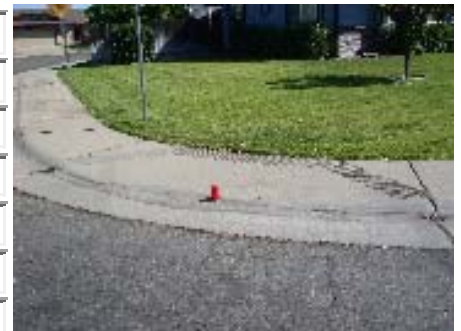
Field Date:	9/28/2010	Report Date:	9/28/2010	Barrier #:	13D
Location:	Julie Lynn Ct and Imran Woods Cir - Corner C				
X Coordinate:	-121.30697				
Y Coordinate:	38.72230				
Barrier Area:	Curb Ramps				
Barrier Type:	Lip - Gutter to Asphalt Transition				
Code Ref:	CBC 1127B.5.3 and ADA/ABA 303.3

As Built Meas:	1	Quantity:	EACH
Description:	Transition at transition into asphalt not flush and free of any lip		
As Built Desc:	1" lip at asphalt transition into roadway		
Solution:	Remove lip to create flush transition		
Bar. Severity:	1 Necessary	Cost Estimate:	\$0.00
Implementation Priority:	4	Facility Function:	
Implementation Phase:		Implementation Date:	
Official Responsible:			
Notes:	Two - way intersection corners C,D

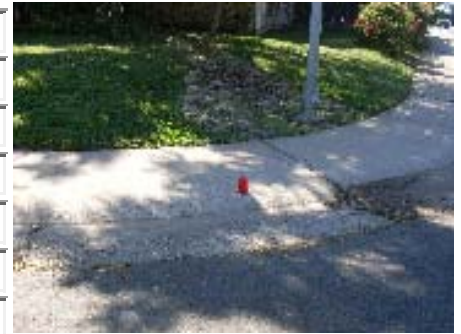
Barrier Type: No Curb Ramp

Code Ref: CBC 1127B.5.1 and ADA/ABA 402.2

As Built Meas: 1 Quantity: EACH

Description: No curb cut at corner (intersection)

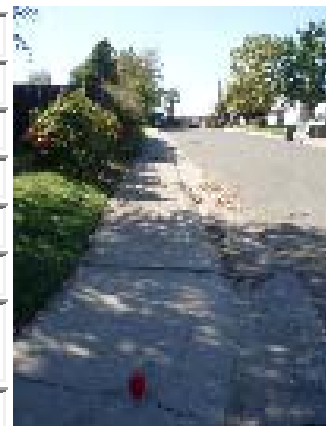
Barrier Type: Cross Slope - New Construction

Code Ref: CBC 1133B.7.1.3 and ADA/ABA 403.3

As Built Meas: 871 Quantity: LF

Description: Cross slope exceeds 2.0% in new construction

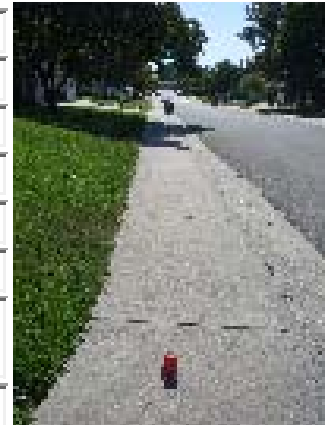
Field Date:	9/28/2010	Report Date:	9/28/2010	Barrier #:	16A
Location:	Irman Woods Cir - East				
X Coordinate:	-121.30856				
Y Coordinate:	38.72239				
Barrier Area:	Sidewalks				
Barrier Type:	Cross Slope - Existing (5.0% or more)				
Code Ref:	CBC 1133B.7.1.3 and ADA/ABA 403.3				
As Built Meas:	375	Quantity:	LF		
Description:	Cross slope exceeds 2.0% (5.0% or more)				
As Built Desc:	6.1% cross slope				
Solution:	Demolish existing and construct new route				
Bar. Severity:	1 Necessary	Cost Estimate:	\$46,875.00	Status:	
Implementation Priority:	4	Facility Function:			
Implementation Phase:		Implementation Date:			
Official Responsible:

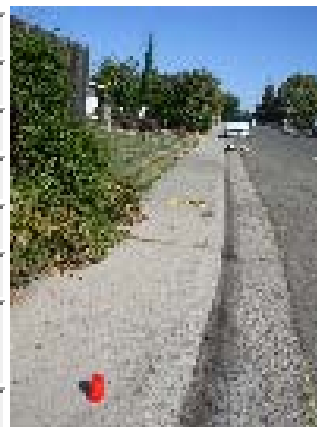
Barrier Type: Cross Slope - Existing (5.0% or more)

Code Ref: CBC 1133B.7.1.3 and ADA/ABA 403.3

As Built Meas: 324 Quantity: LF

Description: Cross slope exceeds 2.0% (5.0% or more)

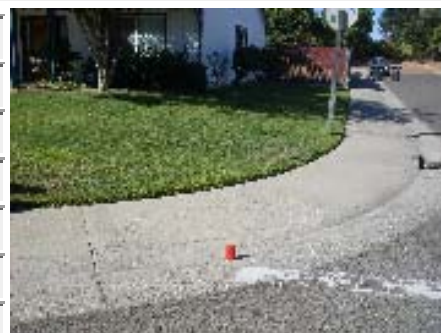
Barrier Type: No Curb Ramp - Depressed Existing Curb

Code Ref: CBC 1127B.5.1 and ADA/ABA 402.2

As Built Meas: 1 Quantity: EACH

Description: No compliant curb cut at corner (intersection)

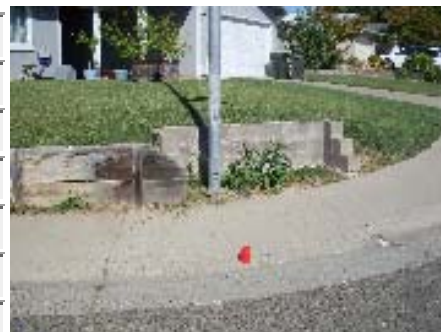
Barrier Type: No Curb Ramp - Depressed Existing Curb

Code Ref: CBC 1127B.5.1 and ADA/ABA 402.2

As Built Meas: 1 Quantity: EACH

Description: No compliant curb cut at corner (intersection)

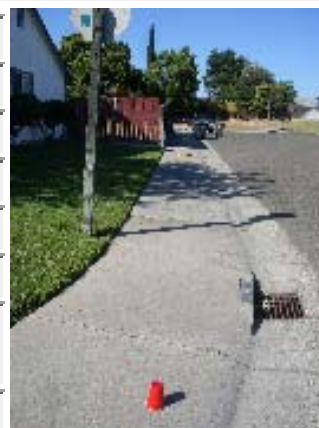
Barrier Type: Cross Slope - New Construction

Code Ref: CBC 1133B.7.1.3 and ADA/ABA 403.3

As Built Meas: 148 Quantity: LF

Description: Cross slope exceeds 2.0% in new construction

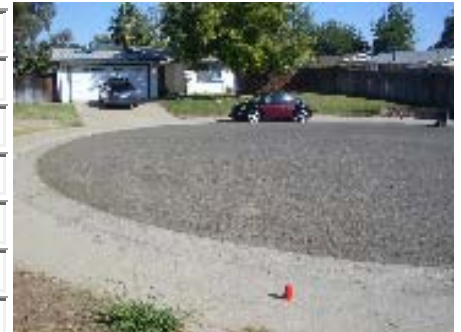
Barrier Type: Cross Slope - New Construction

Code Ref: CBC 1133B.7.1.3 and ADA/ABA 403.3

As Built Meas: 128 Quantity: LF

Description: Cross slope exceeds 2.0% in new construction

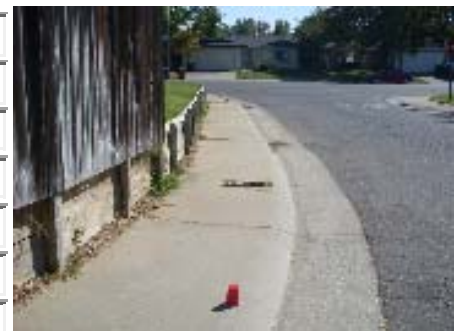
Barrier Type: Cross Slope - New Construction

Code Ref: CBC 1133B.7.1.3 and ADA/ABA 403.3

As Built Meas: 124 Quantity: LF

Description: Cross slope exceeds 2.0% in new construction

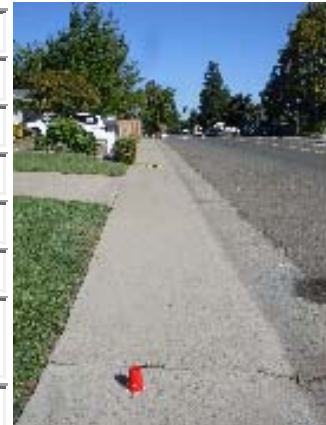
Barrier Type: Cross Slope - New Construction

Code Ref: CBC 1133B.7.1.3 and ADA/ABA 403.3

As Built Meas: 260 Quantity: LF

Description: Cross slope exceeds 2.0% in new construction

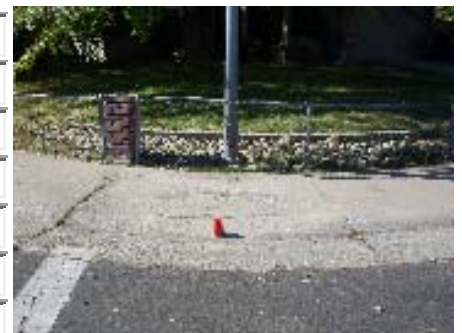
Barrier Type: No Curb Ramp - Depressed Existing Curb

Code Ref: CBC 1127B.5.1 and ADA/ABA 402.2

As Built Meas: 1 Quantity: EACH

Description: No compliant curb cut at corner (intersection)

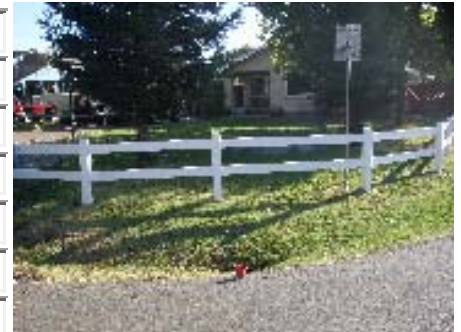
Barrier Type: Detectable Warnings - Truncated Domes

Code Ref: CBC 1127B.5.3

As Built Meas: 1 Quantity: EACH

Description: No truncated domes provided at transition into roadway

Bar. Severity: 2 Recommended

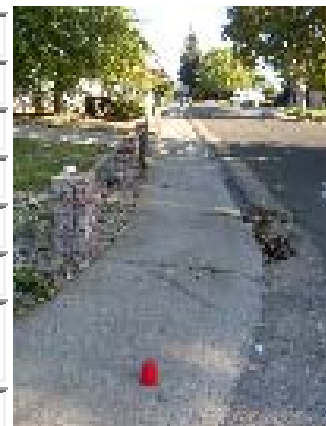
Barrier Type: Cross Slope - Existing (5.0% or more)

Code Ref: CBC 1133B.7.1.3 and ADA/ABA 403.3

As Built Meas: 287 Quantity: LF

Description: Cross slope exceeds 2.0% (5.0% or more)

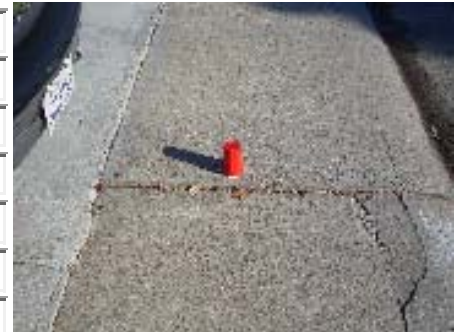
Barrier Type: Abrupt Change in Level - > 1/2"

Code Ref: CBC 1133B.7.1 and ADA/ABA 303.3

As Built Meas: 4 Quantity: LF

Description: Change in level greater than 1/2"

Solution: Grind or repair sidewalk to remove trip hazard

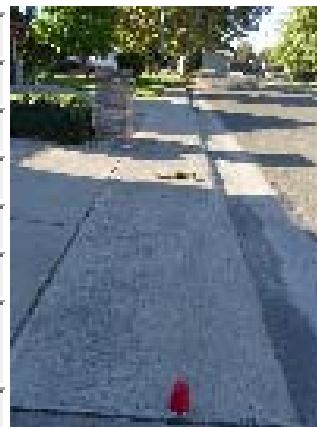
Barrier Type: Cross Slope - Existing (5.0% or more)

Code Ref: CBC 1133B.7.1.3 and ADA/ABA 403.3

As Built Meas: 107 Quantity: LF

Description: Cross slope exceeds 2.0% (5.0% or more)

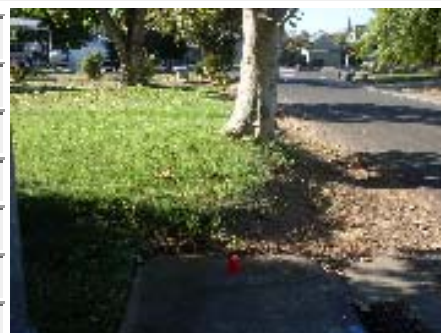
Barrier Type: No Sidewalk - No Barricade

Code Ref: MUTCD Section 6D.01

As Built Meas: 1 Quantity: JOB

Description: No barricade provided where sidewalk ends in hazardous location

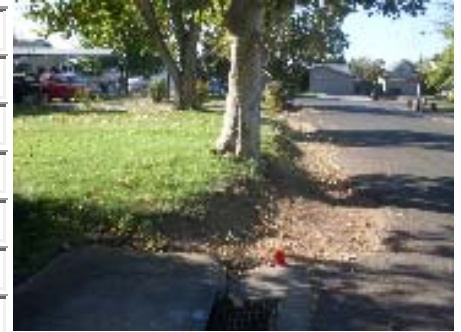
Field Date:	9/29/2010	Report Date:	9/29/2010	Barrier #:	28B
Location:	Imran Woods Cir - East				
X Coordinate:	-121.30706				
Y Coordinate:	38.72181				
Barrier Area:	Sidewalks				
Barrier Type:	No sidewalk				
Code Ref:	CBC 1127B.1 and ADA/ABA 206.2.1

As Built Meas:	149	Quantity:	LF
Description:	No pedestrian route provided		
As Built Desc:	No sidewalk provided		
Solution:	Construct new firm and stable pedestrian route		
Bar. Severity:	1 Necessary	Cost Estimate:	\$14,900.00
Implementation Priority:	4	Facility Function:	
Implementation Phase:		Implementation Date:	
Official Responsible:			
Notes:

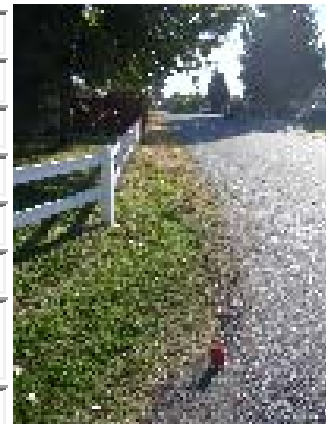
Field Date:	9/29/2010	Report Date:	9/29/2010	Barrier #:	29
Location:	Whyte Ave - North				
X Coordinate:	-121.30703				
Y Coordinate:	38.72139				
Barrier Area:	Sidewalks				
Barrier Type:	No sidewalk				
Code Ref:	CBC 1127B.1 and ADA/ABA 206.2.1

As Built Meas:	249	Quantity:	LF
Description:	No pedestrian route provided		
As Built Desc:	No sidewalk provided		
Solution:	Construct new firm and stable pedestrian route		
Bar. Severity:	1 Necessary	Cost Estimate:	\$24,900.00
Implementation Priority:	4	Facility Function:	
Implementation Phase:		Implementation Date:	
Official Responsible:			
Notes:

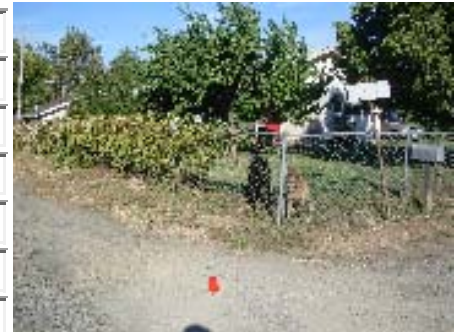
Barrier Type: Detectable Warnings - Truncated Domes

Code Ref: CBC 1127B.5.3

As Built Meas: 1 Quantity: EACH

Description: No truncated domes provided at transition into roadway

Bar. Severity: 2 Recommended

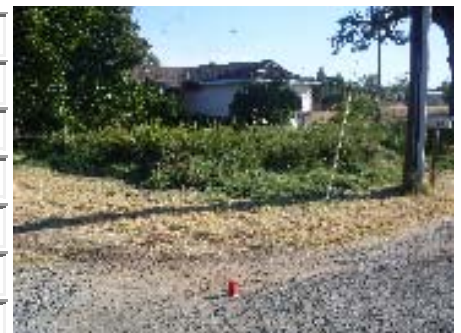
Barrier Type: Detectable Warnings - Truncated Domes

Code Ref: CBC 1127B.5.3

As Built Meas: 1 Quantity: EACH

Description: No truncated domes provided at transition into roadway

Bar. Severity: 2 Recommended

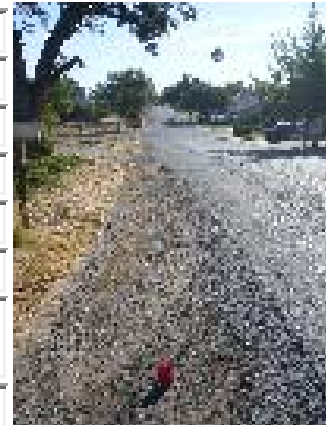
Barrier Type: No sidewalk

Code Ref: CBC 1127B.1 and ADA/ABA 206.2.1

As Built Meas: 201 Quantity: LF

Description: No pedestrian route provided

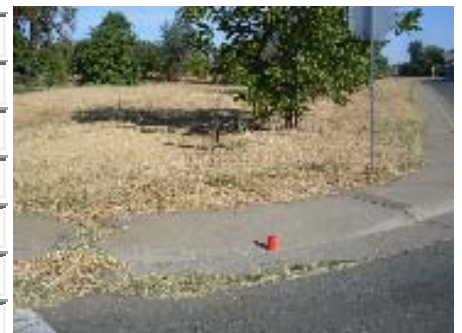
Barrier Type: No Curb Ramp - Depressed Existing Curb

Code Ref: CBC 1127B.5.1 and ADA/ABA 402.2

As Built Meas: 1 Quantity: EACH

Description: No compliant curb cut at corner (intersection)

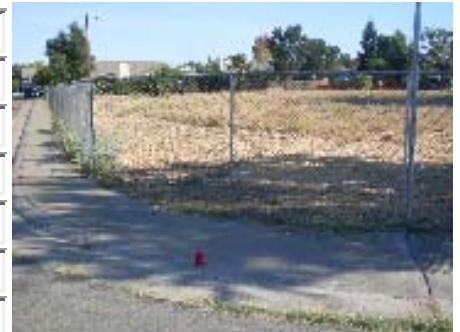
Field Date:	9/29/2010	Report Date:	9/29/2010	Barrier #:	34
Location:	Whyte Ave and Lichen Dr - Corner B				
X Coordinate:	-121.30503				
Y Coordinate:	38.72146				
Barrier Area:	Curb Ramps				
Barrier Type:	No Curb Ramp - Depressed Existing Curb				
Code Ref:	CBC 1127B.5.1 and ADA/ABA 402.2

As Built Meas:	1	Quantity:	EACH
Description:	No compliant curb cut at corner (intersection)		
As Built Desc:	11.2% running slope at depressed area		
Solution:	Demolish existing and construct curb cut		
Bar. Severity:	1 Necessary	Cost Estimate:	\$2,500.00
Implementation Priority:	4	Facility Function:	
Implementation Phase:		Implementation Date:	
Official Responsible:			
Notes:	Four - way intersection corners A,B,C,D

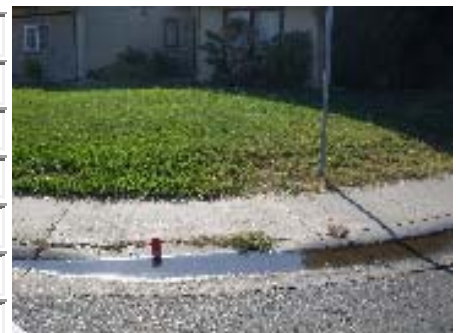
Field Date:	9/30/2010	Report Date:	9/30/2010	Barrier #:	35
Location:	Whyte Ave and Lichen Dr - Corner C				
X Coordinate:	-121.30496				
Y Coordinate:	38.72129				
Barrier Area:	Curb Ramps				
Barrier Type:	No Curb Ramp - Depressed Existing Curb				
Code Ref:	CBC 1127B.5.1 and ADA/ABA 402.2

As Built Meas:	1	Quantity:	EACH
Description:	No compliant curb cut at corner (intersection)		
As Built Desc:	9.6% running slope at depressed area		
Solution:	Demolish existing and construct curb cut		
Bar. Severity:	1 Necessary	Cost Estimate:	\$2,500.00
Implementation Priority:	4	Facility Function:	
Implementation Phase:		Implementation Date:	
Official Responsible:			
Notes:	Four - way intersection corners A,B,C,D

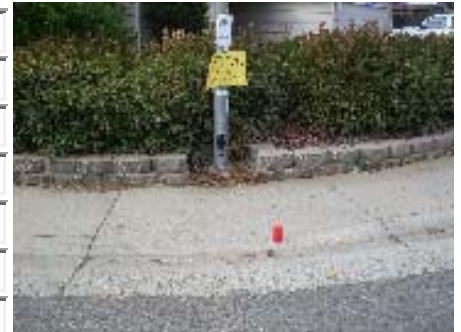
Field Date: 10/4/2010 Report Date: 10/4/2010 Barrier #: 36

Barrier Type: No Curb Ramp - Depressed Existing Curb

Code Ref: CBC 1127B.5.1 and ADA/ABA 402.2

As Built Meas: 1 Quantity: EACH

Description: No compliant curb cut at corner (intersection)

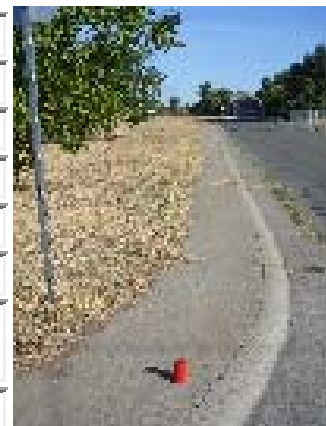
Barrier Type: Cross Slope - Existing (5.0% or more)

Code Ref: CBC 1133B.7.1.3 and ADA/ABA 403.3

As Built Meas: 457 Quantity: LF

Description: Cross slope exceeds 2.0% (5.0% or more)

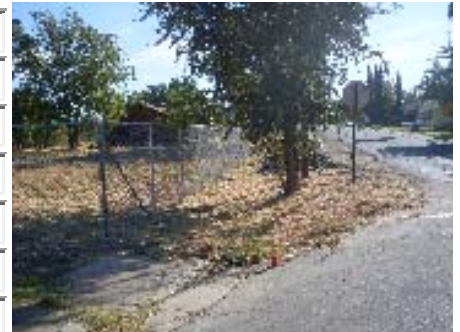
Field Date:	9/29/2010	Report Date:	9/29/2010	Barrier #:	38A
Location:	Whyte Ave - North				
X Coordinate:	-121.30502				
Y Coordinate:	38.72144				
Barrier Area:	Sidewalks				
Barrier Type:	No Sidewalk - No Barricade				
Code Ref:	MUTCD Section 6D.01

As Built Meas:	1	Quantity:	JOB
Description:	No barricade provided where sidewalk ends in hazardous location		
As Built Desc:	No barricade or other warning provided for the visually impaired at end of sidewalk		
Solution:	Provide barricade with cane detectable warning at end of sidewalk		
Bar. Severity:	1 Necessary	Cost Estimate:	\$1,350.00
Implementation Priority:	4	Facility Function:	
Implementation Phase:		Implementation Date:	
Official Responsible:			
Notes:

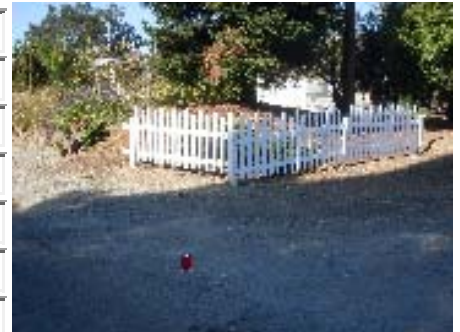
Barrier Type: No sidewalk

Code Ref: CBC 1127B.1 and ADA/ABA 206.2.1

As Built Meas: 1597 Quantity: LF

Description: No pedestrian route provided

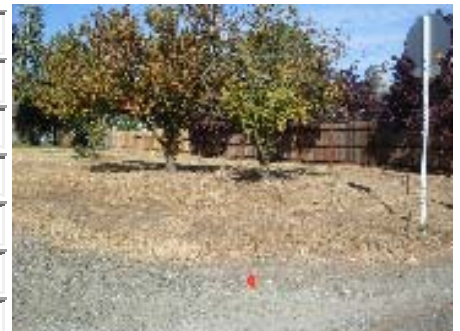
Barrier Type: Detectable Warnings - Truncated Domes

Code Ref: CBC 1127B.5.3

As Built Meas: 1 Quantity: EACH

Description: No truncated domes provided at transition into roadway

Bar. Severity: 2 Recommended Cost Estimate: \$1,400.00 Status:

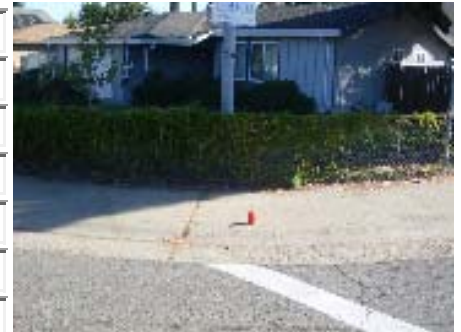
Field Date:	9/29/2010	Report Date:	9/29/2010	Barrier #:	41
Location:	Whyte Ave and Vernon St - Corner B				
X Coordinate:	-121.29957				
Y Coordinate:	38.72211				
Barrier Area:	Curb Ramps				
Barrier Type:	No Curb Ramp				
Code Ref:	CBC 1127B.5.1 and ADA/ABA 402.2

As Built Meas:	1	Quantity:	EACH
Description:	No curb cut at corner (intersection)		
As Built Desc:	No curb ramp at corner		
Solution:	Demolish existing and construct curb cut		
Bar. Severity:	1 Necessary	Cost Estimate:	\$2,500.00
Implementation Priority:	4	Facility Function:	
Implementation Phase:		Implementation Date:	
Official Responsible:			
Notes:	Four - way intersection corners A,B,C,D

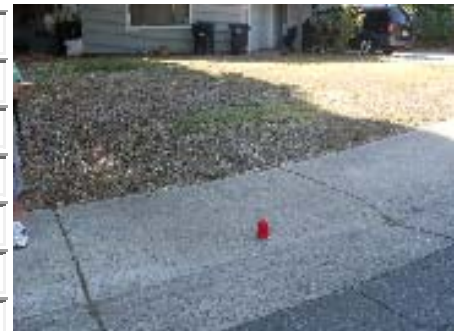
Field Date:	9/30/2010	Report Date:	9/30/2010	Barrier #:	42
Location:	Whyte Ave and Vernon St - Corner C				
X Coordinate:	-121.29964				
Y Coordinate:	38.72190				
Barrier Area:	Curb Ramps				
Barrier Type:	No Curb Ramp - Depressed Existing Curb				
Code Ref:	CBC 1127B.5.1 and ADA/ABA 402.2

As Built Meas:	1	Quantity:	EACH
Description:	No compliant curb cut at corner (intersection)		
As Built Desc:	9.9% running slope at depressed area		
Solution:	Demolish existing and construct curb cut		
Bar. Severity:	1 Necessary	Cost Estimate:	\$2,500.00
Implementation Priority:	4	Facility Function:	
Implementation Phase:		Implementation Date:	
Official Responsible:			
Notes:	Four - way intersection corners A,B,C,D

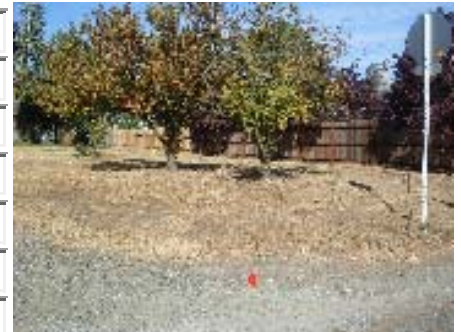
Field Date: 9/29/2010 Report Date: 9/29/2010 Barrier #: 43

Barrier Type: Detectable Warnings - Truncated Domes

Code Ref: CBC 1127B.5.3

As Built Meas: 1 Quantity: EACH

Description: No truncated domes provided at transition into roadway

Bar. Severity: 2 Recommended Cost Estimate: \$1,400.00 Status:

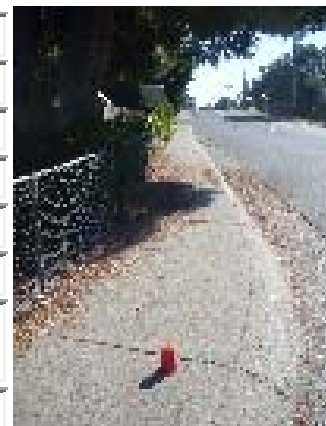
Barrier Type: Cross Slope - Existing (4.1% to 4.9%)

Code Ref: CBC 1133B.7.1.3 and ADA/ABA 403.3

As Built Meas: 187 Quantity: LF

Description: Cross slope exceeds 2.0% (4.1% to 4.9%)

Bar. Severity: 2 Recommended Cost Estimate: \$23,375.00 Status:

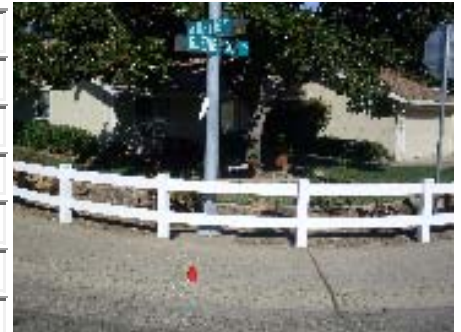
Field Date:	9/29/2010	Report Date:	9/29/2010	Barrier #:	45
Location:	Whyte Ave and Glenbrook Ave - Corner A				
X Coordinate:	-121.29886				
Y Coordinate:	38.72213				
Barrier Area:	Curb Ramps				
Barrier Type:	No Curb Ramp				
Code Ref:	CBC 1127B.5.1 and ADA/ABA 402.2

As Built Meas:	1	Quantity:	EACH
Description:	No curb cut at corner (intersection)		
As Built Desc:	No curb ramp at corner		
Solution:	Demolish existing and construct curb cut		
Bar. Severity:	1 Necessary	Cost Estimate:	\$2,500.00
Implementation Priority:	4	Facility Function:	
Implementation Phase:		Implementation Date:	
Official Responsible:			
Notes:	Two - way intersection corners A,B

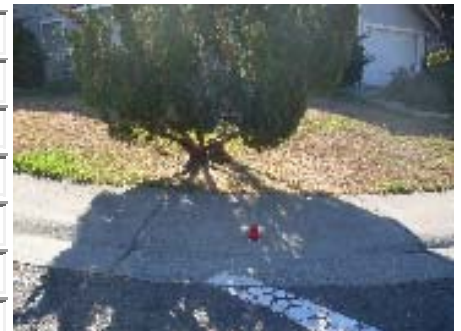
Field Date:	9/29/2010	Report Date:	9/29/2010	Barrier #:	46
Location:	Whyte Ave and Blue Springs Wy - Corner C				
X Coordinate:	-121.29889				
Y Coordinate:	38.72194				
Barrier Area:	Curb Ramps				
Barrier Type:	No Curb Ramp - Depressed Existing Curb				
Code Ref:	CBC 1127B.5.1 and ADA/ABA 402.2

As Built Meas:	1	Quantity:	EACH
Description:	No compliant curb cut at corner (intersection)		
As Built Desc:	12.4% running slope at depressed area		
Solution:	Demolish existing and construct curb cut		
Bar. Severity:	1 Necessary	Cost Estimate:	\$2,500.00
Implementation Priority:	4	Facility Function:	
Implementation Phase:		Implementation Date:	
Official Responsible:			
Notes:	Two - way intersection corners C,D

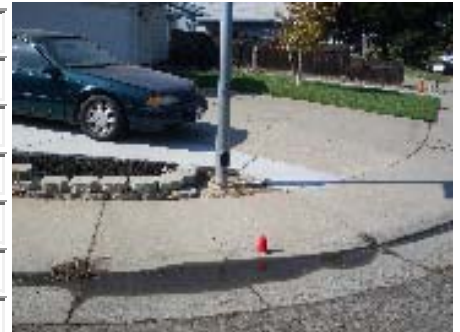
Field Date: 9/30/2010 Report Date: 9/30/2010 Barrier #: 47

Barrier Type: No Curb Ramp - Depressed Existing Curb

Code Ref: CBC 1127B.5.1 and ADA/ABA 402.2

As Built Meas: 1 Quantity: EACH

Description: No compliant curb cut at corner (intersection)

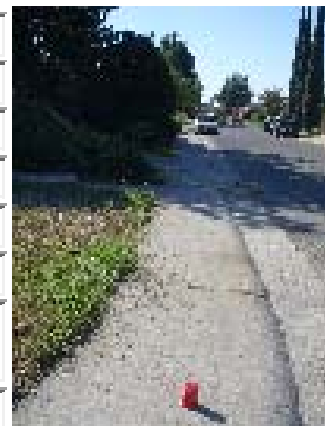
Barrier Type: Cross Slope - Existing (5.0% or more)

Code Ref: CBC 1133B.7.1.3 and ADA/ABA 403.3

As Built Meas: 439 Quantity: LF

Description: Cross slope exceeds 2.0% (5.0% or more)

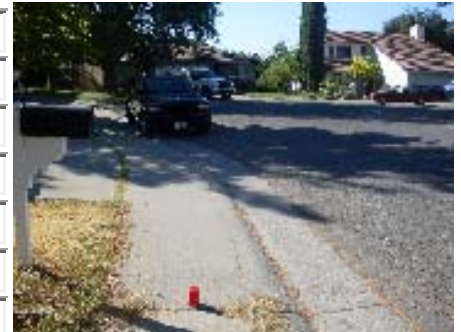
Field Date:	9/29/2010	Report Date:	9/29/2010	Barrier #:	49
Location:	Blue Springs Wy - East				
X Coordinate:	-121.29891				
Y Coordinate:	38.72075				
Barrier Area:	Sidewalks				
Barrier Type:	Cross Slope - Existing (5.0% or more)				
Code Ref:	CBC 1133B.7.1.3 and ADA/ABA 403.3

As Built Meas:	151	Quantity:	LF		
Description:	Cross slope exceeds 2.0% (5.0% or more)				
As Built Desc:	5.8% cross slope				
Solution:	Demolish existing and construct new route				
Bar. Severity:	1 Necessary	Cost Estimate:	\$18,875.00	Status:	
Implementation Priority:	4	Facility Function:			
Implementation Phase:		Implementation Date:			
Official Responsible:					
Notes:

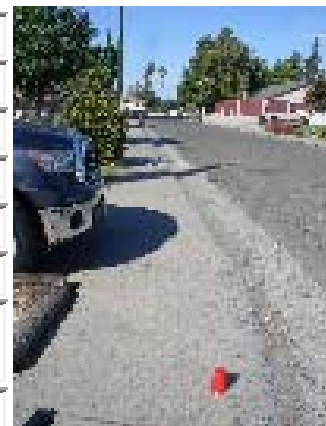
Field Date:	9/29/2010	Report Date:	9/29/2010	Barrier #:	50
Location:	Blue Springs Wy - South				
X Coordinate:	-121.29913				
Y Coordinate:	38.72051				
Barrier Area:	Sidewalks				
Barrier Type:	Cross Slope - Existing (5.0% or more)				
Code Ref:	CBC 1133B.7.1.3 and ADA/ABA 403.3

As Built Meas:	261	Quantity:	LF		
Description:	Cross slope exceeds 2.0% (5.0% or more)				
As Built Desc:	5.3% cross slope				
Solution:	Demolish existing and construct new route				
Bar. Severity:	1 Necessary	Cost Estimate:	\$32,625.00	Status:	
Implementation Priority:	4	Facility Function:			
Implementation Phase:		Implementation Date:			
Official Responsible:					
Notes:

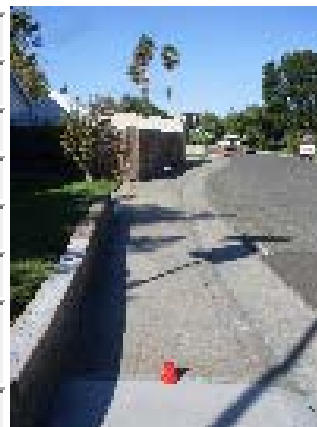
Field Date: 9/29/2010 Report Date: 9/29/2010 Barrier #: 51

Barrier Type: Cross Slope - Existing (5.0% or more)

Code Ref: CBC 1133B.7.1.3 and ADA/ABA 403.3

As Built Meas: 154 Quantity: LF

Description: Cross slope exceeds 2.0% (5.0% or more)

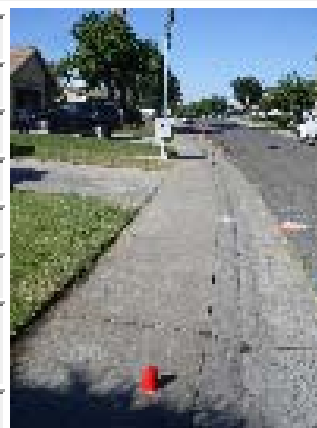
Barrier Type: Cross Slope - Existing (5.0% or more)

Code Ref: CBC 1133B.7.1.3 and ADA/ABA 403.3

As Built Meas: 145 Quantity: LF

Description: Cross slope exceeds 2.0% (5.0% or more)

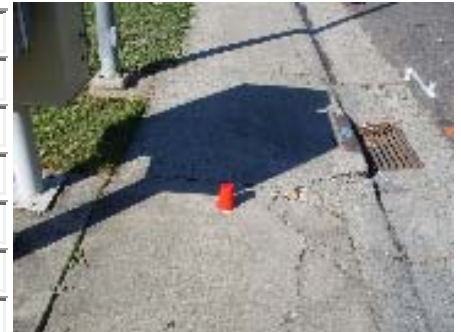
Barrier Type: Surface Condition - Damaged

Code Ref: CBC 1133B.7.1 and ADA/ABA 302.1

As Built Meas: 4 Quantity: LF

Description: Surface is not firm and stable (cracked, broken or loose soil, etc.)

As Built Desc: Cracked concrete

Solution: Repair surface to make firm and stable

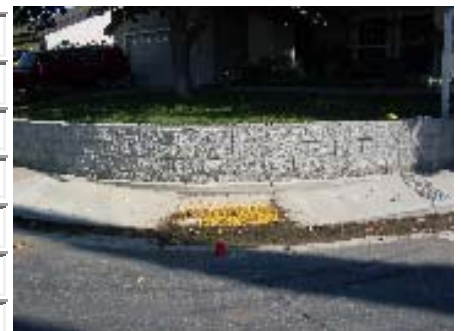
Barrier Type: Water Accumulation - Existing

Code Ref: CBC 1133B.5.8 and ADA/ABA 405.10

As Built Meas: 1 Quantity: EACH

Description: Water does not drain off of curb ramp

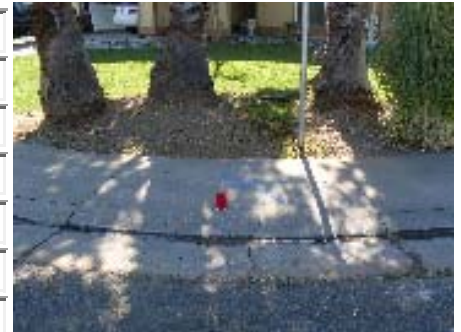
Barrier Type: No Curb Ramp - Depressed Existing Curb

Code Ref: CBC 1127B.5.1 and ADA/ABA 402.2

As Built Meas: 1 Quantity: EACH

Description: No compliant curb cut at corner (intersection)

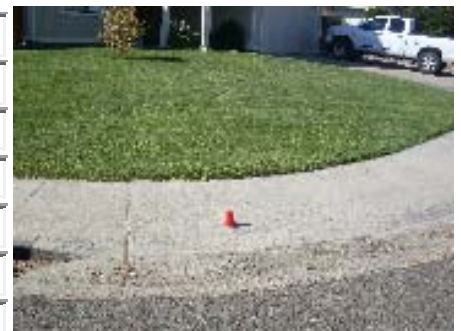
Barrier Type: No Curb Ramp - Depressed Existing Curb

Code Ref: CBC 1127B.5.1 and ADA/ABA 402.2

As Built Meas: 1 Quantity: EACH

Description: No compliant curb cut at corner (intersection)

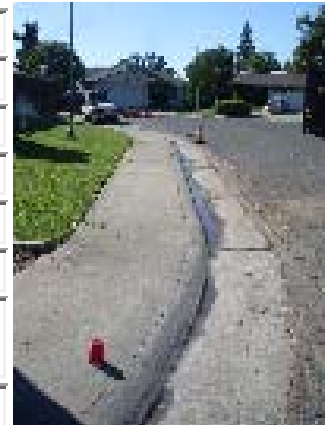
Field Date:	9/29/2010	Report Date:	9/29/2010	Barrier #:	56
Location:	Whiteplains Ct - East				
X Coordinate:	-121.30142				
Y Coordinate:	38.72056				
Barrier Area:	Sidewalks				
Barrier Type:	Cross Slope - Existing (5.0% or more)				
Code Ref:	CBC 1133B.7.1.3 and ADA/ABA 403.3

As Built Meas:	150	Quantity:	LF
Description:	Cross slope exceeds 2.0% (5.0% or more)		
As Built Desc:	7.1% cross slope		
Solution:	Demolish existing and construct new route		
Bar. Severity:	1 Necessary	Cost Estimate:	\$18,750.00
Implementation Priority:	4	Facility Function:	
Implementation Phase:		Implementation Date:	
Official Responsible:

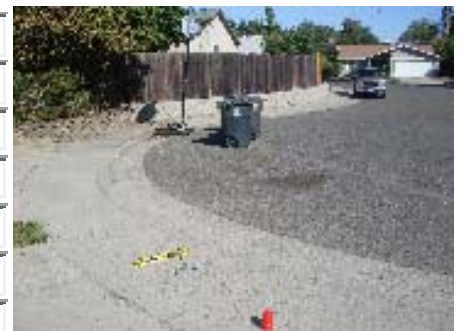
Field Date:	9/29/2010	Report Date:	9/29/2010	Barrier #:	57
Location:	Whiteplains Ct - West				
X Coordinate:	-121.30153				
Y Coordinate:	38.72022				
Barrier Area:	Sidewalks				
Barrier Type:	Cross Slope - Existing (5.0% or more)				
Code Ref:	CBC 1133B.7.1.3 and ADA/ABA 403.3

As Built Meas:	166	Quantity:	LF
Description:	Cross slope exceeds 2.0% (5.0% or more)		
As Built Desc:	6.1% cross slope		
Solution:	Demolish existing and construct new route		
Bar. Severity:	1 Necessary	Cost Estimate:	\$20,750.00
Implementation Priority:	4	Facility Function:	
Implementation Phase:		Implementation Date:	
Official Responsible:

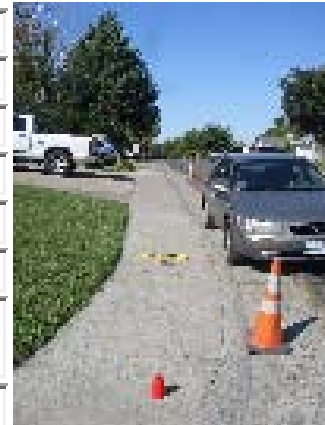
Barrier Type: Cross Slope - Existing (5.0% or more)

Code Ref: CBC 1133B.7.1.3 and ADA/ABA 403.3

As Built Meas: 236 Quantity: LF

Description: Cross slope exceeds 2.0% (5.0% or more)

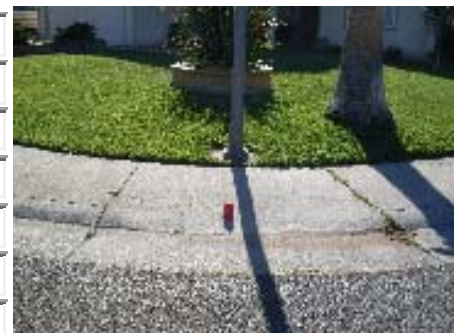
Barrier Type: No Curb Ramp - Depressed Existing Curb

Code Ref: CBC 1127B.5.1 and ADA/ABA 402.2

As Built Meas: 1 Quantity: EACH

Description: No compliant curb cut at corner (intersection)

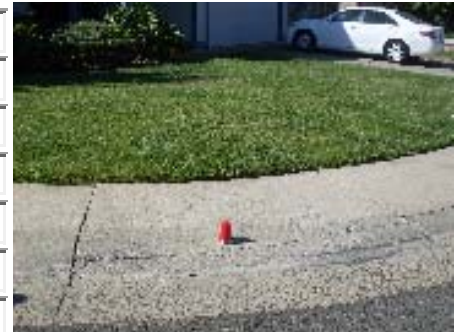
Barrier Type: No Curb Ramp - Depressed Existing Curb

Code Ref: CBC 1127B.5.1 and ADA/ABA 402.2

As Built Meas: 1 Quantity: EACH

Description: No compliant curb cut at corner (intersection)

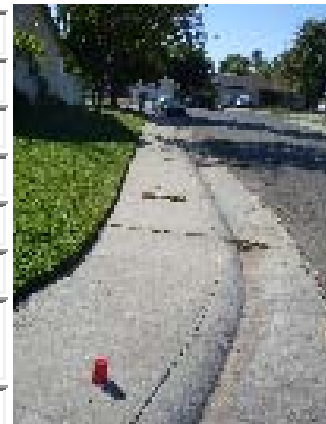
Barrier Type: Cross Slope - Existing (5.0% or more)

Code Ref: CBC 1133B.7.1.3 and ADA/ABA 403.3

As Built Meas: 227 Quantity: LF

Description: Cross slope exceeds 2.0% (5.0% or more)

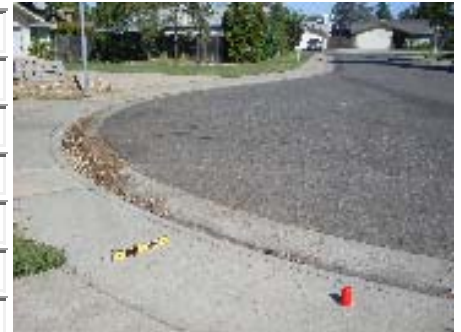
Barrier Type: Cross Slope - Existing (5.0% or more)

Code Ref: CBC 1133B.7.1.3 and ADA/ABA 403.3

As Built Meas: 216 Quantity: LF

Description: Cross slope exceeds 2.0% (5.0% or more)

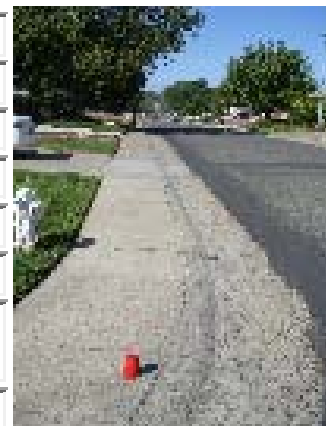
Barrier Type: Cross Slope - Existing (5.0% or more)

Code Ref: CBC 1133B.7.1.3 and ADA/ABA 403.3

As Built Meas: 475 Quantity: LF

Description: Cross slope exceeds 2.0% (5.0% or more)

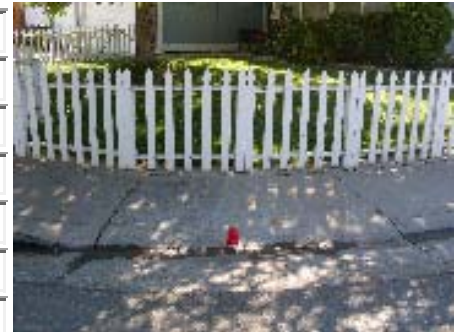
Barrier Type: No Curb Ramp - Depressed Existing Curb

Code Ref: CBC 1127B.5.1 and ADA/ABA 402.2

As Built Meas: 1 Quantity: EACH

Description: No compliant curb cut at corner (intersection)

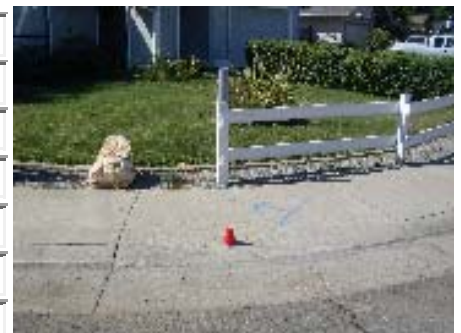
Barrier Type: No Curb Ramp - Depressed Existing Curb

Code Ref: CBC 1127B.5.1 and ADA/ABA 402.2

As Built Meas: 1 Quantity: EACH

Description: No compliant curb cut at corner (intersection)

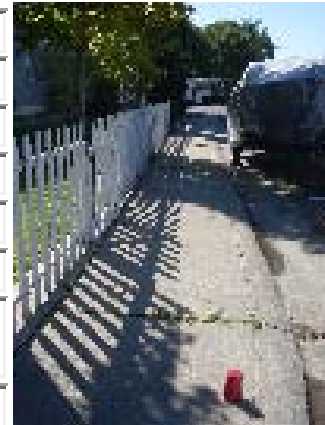
Barrier Type: Cross Slope - Existing (5.0% or more)

Code Ref: CBC 1133B.7.1.3 and ADA/ABA 403.3

As Built Meas: 222 Quantity: LF

Description: Cross slope exceeds 2.0% (5.0% or more)

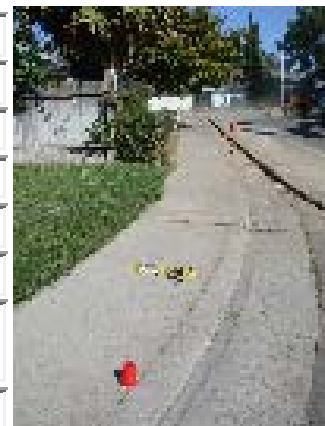
Barrier Type: Cross Slope - Existing (5.0% or more)

Description: Cross slope exceeds 2.0% (5.0% or more)

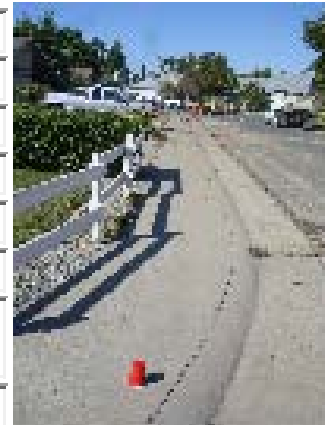
Barrier Type: Cross Slope - Existing (5.0% or more)

Description: Cross slope exceeds 2.0% (5.0% or more)

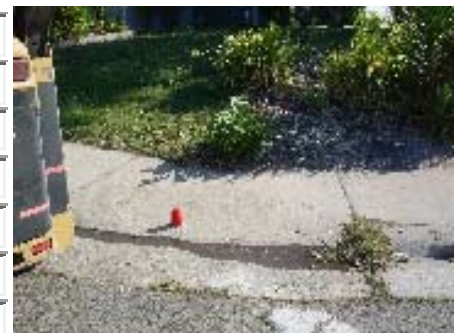
Barrier Type: No Curb Ramp - Depressed Existing Curb

Description: No compliant curb cut at corner (intersection)

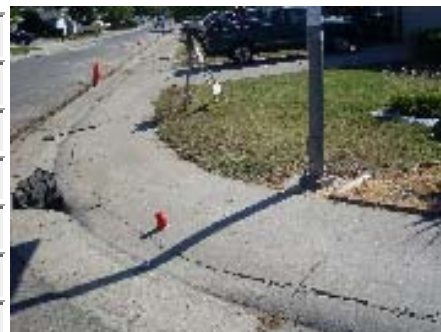
Barrier Type: No Curb Ramp - Depressed Existing Curb

Description: No compliant curb cut at corner (intersection)

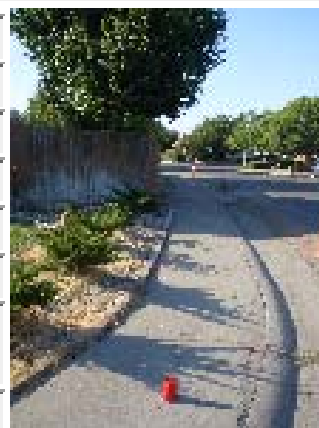
Barrier Type: Cross Slope - Existing (5.0% or more)

Description: Cross slope exceeds 2.0% (5.0% or more)

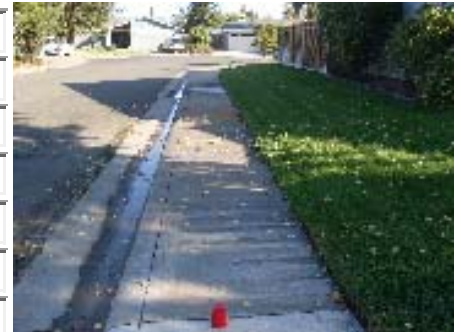
Barrier Type: Cross Slope - Existing (4.1% to 4.9%)

Description: Cross slope exceeds 2.0% (4.1% to 4.9%)

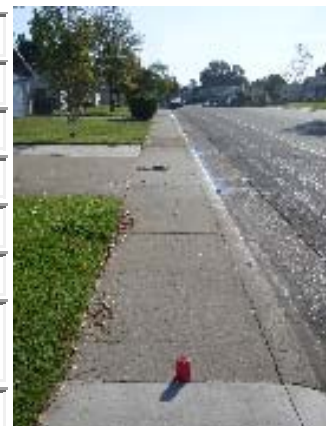
Barrier Type: Cross Slope - Existing (4.1% to 4.9%)

Description: Cross slope exceeds 2.0% (4.1% to 4.9%)

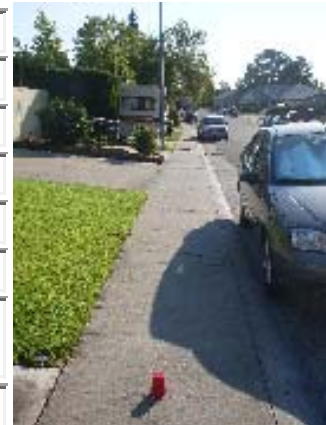
Barrier Type: Cross Slope - Existing (4.1% to 4.9%)

Description: Cross slope exceeds 2.0% (4.1% to 4.9%)

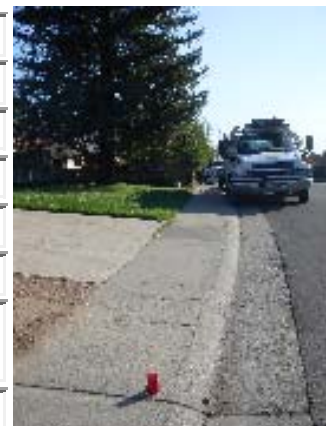
Barrier Type: Cross Slope - Existing (4.1% to 4.9%)

Description: Cross slope exceeds 2.0% (4.1% to 4.9%)

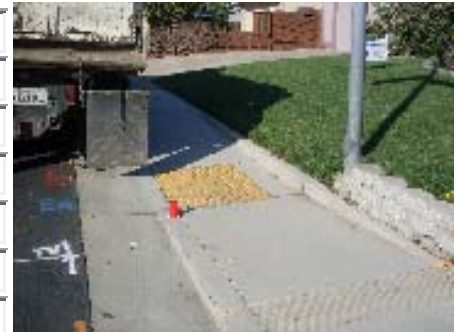
Barrier Type: 12" Grooves - New Construction

Description: 12" grooves at top of curb ramp are not level (>5.0%)

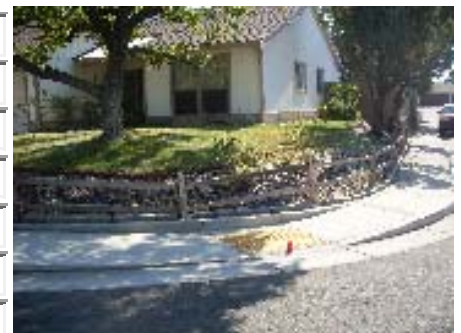
Barrier Type: 12" Grooves - New Construction

Description: 12" grooves at top of curb ramp are not level (>5.0%)

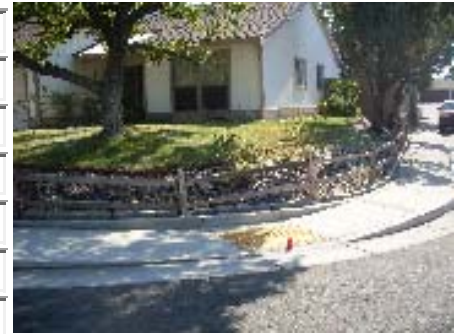
Field Date:	9/30/2010	Report Date:	9/30/2010	Barrier #:	79B
Location:	Canevalley Cir and Mountainside Dr - Corner C				
X Coordinate:	-121.30439				
Y Coordinate:	38.71933				
Barrier Area:	Curb Ramps				
Barrier Type:	Perpendicular Ramp Landing - New Construction				
Code Ref:	CBC 1127B.5.4 and ADA/ABA 406.4

As Built Meas:	1	Quantity:	EACH
Description:	Curb ramp landing or pan not level (>5.0% or more)		
As Built Desc:	5.1% landing slope		
Solution:	Demolish existing and construct new transition		
Bar. Severity:	1 Necessary	Cost Estimate:	\$0.00
Implementation Priority:	4	Facility Function:	
Implementation Phase:		Implementation Date:	
Official Responsible:			
Notes:	Three - way intersection corners A,C,D

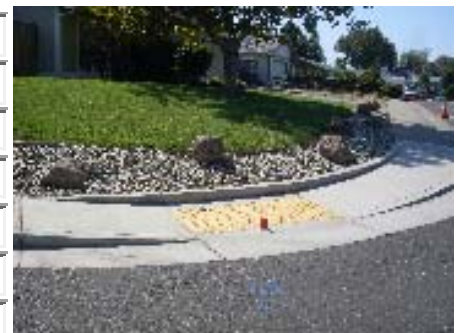
Field Date:	9/30/2010	Report Date:	9/30/2010	Barrier #:	80
Location:	Canevalley Cir and Mountainside Dr - Corner D				
X Coordinate:	-121.30117				
Y Coordinate:	38.71952				
Barrier Area:	Curb Ramps				
Barrier Type:	Parallel Ramp Landing - New Construction				
Code Ref:	CBC 1127B.5.4 and ADA/ABA 406.4

As Built Meas:	1	Quantity:	EACH
Description:	Curb ramp landing or pan not level(4.1% to 4.9%)		
As Built Desc:	4.3% landing slope		
Solution:	Demolish existing and construct new transition		
Bar. Severity:	1 Necessary	Cost Estimate:	\$250.00
Implementation Priority:	4	Facility Function:	
Implementation Phase:		Implementation Date:	
Official Responsible:			
Notes:	Three - way intersection corners A,C,D

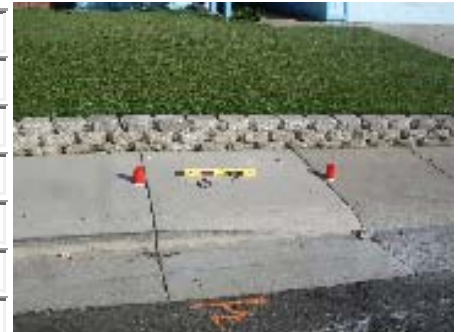
Field Date:	9/30/2010	Report Date:	9/30/2010	Barrier #:	81
Location:	Mountainside Dr - North				
X Coordinate:	-121.30116				
Y Coordinate:	38.71968				
Barrier Area:	Sidewalks				
Barrier Type:	Running Slope (New Construction)				
Code Ref:	CBC 1133B.7.3 and ADA/ABA 403.3

As Built Meas:	4	Quantity:	LF
Description:	Running slope exceeds 5.0%		
As Built Desc:	7.7% running slope		
Solution:	No remediation where sidewalk sloped as roadway		
Bar. Severity:	5 Technically Infeasible	Cost Estimate:	\$0.00
Implementation Priority:	4	Facility Function:	
Implementation Phase:		Implementation Date:	
Official Responsible:			
Notes:

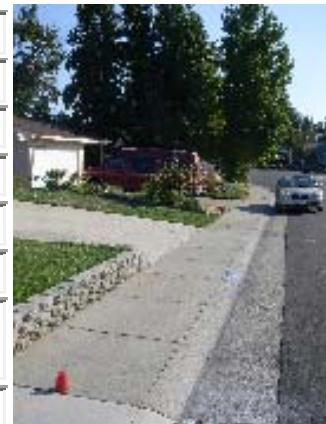
Field Date:	9/30/2010	Report Date:	9/30/2010	Barrier #:	82
Location:	Mountainside Dr - North				
X Coordinate:	-121.30114				
Y Coordinate:	38.71967				
Barrier Area:	Sidewalks				
Barrier Type:	Cross Slope - Existing (5.0% or more)				
Code Ref:	CBC 1133B.7.1.3 and ADA/ABA 403.3

As Built Meas:	159	Quantity:	LF
Description:	Cross slope exceeds 2.0% (5.0% or more)		
As Built Desc:	5.9% cross slope		
Solution:	Demolish existing and construct new route		
Bar. Severity:	1 Necessary	Cost Estimate:	\$19,875.00
Implementation Priority:	4	Facility Function:	
Implementation Phase:		Implementation Date:	
Official Responsible:			
Notes:

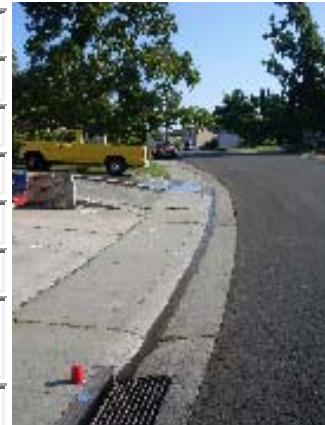
Barrier Type: Cross Slope - Existing (5.0% or more)

Description: Cross slope exceeds 2.0% (5.0% or more)

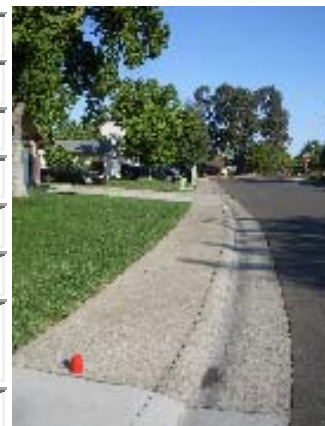
Barrier Type: Cross Slope - Existing (5.0% or more)

Description: Cross slope exceeds 2.0% (5.0% or more)

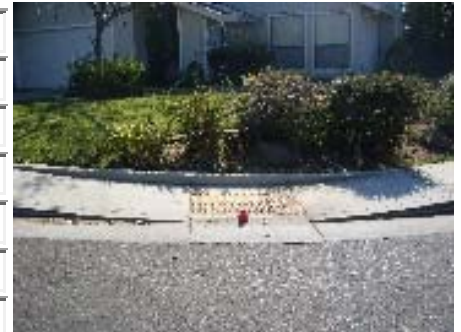
Barrier Type: 12" Grooves - New Construction

Description: 12" grooves at top of curb ramp are not level (4.1% to 4.9%)

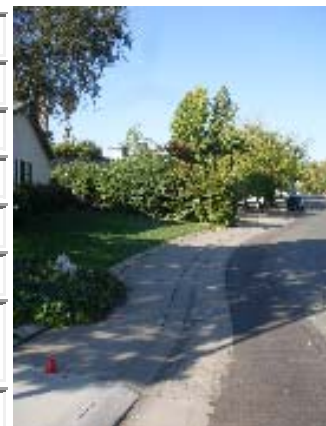
Barrier Type: Cross Slope - Existing (5.0% or more)

Description: Cross slope exceeds 2.0% (5.0% or more)

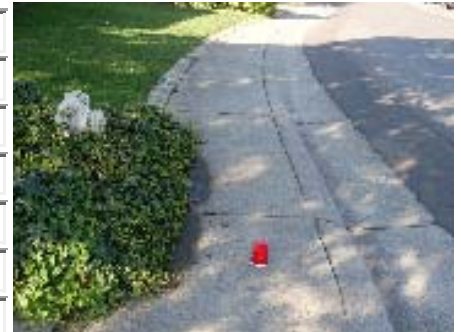
Field Date:	9/30/2010	Report Date:	9/30/2010	Barrier #:	86B
Location:	Whyte Ave - South				
X Coordinate:	-121.30059				
Y Coordinate:	38.72133				
Barrier Area:	Sidewalks				
Barrier Type:	Clear Width - Existing (36" to 43")				
Code Ref:	CBC 1133B.7.1

As Built Meas:	1	Quantity:	LF
Description:	Pedestrian route is not min. 48" wide (36" to 43")		
As Built Desc:	36" clear width due to foliage		
Solution:	Trim foliage to provide min. 48" clear width		
Bar. Severity:	3 Hindrance	Cost Estimate:	\$125.00
Implementation Priority:	4	Facility Function:	
Implementation Phase:		Implementation Date:	
Official Responsible:			
Notes:

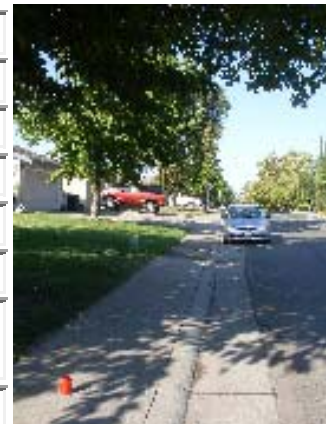
Field Date:	9/30/2010	Report Date:	9/30/2010	Barrier #:	87A
Location:	Whyte Ave - South				
X Coordinate:	-121.30161				
Y Coordinate:	38.72131				
Barrier Area:	Sidewalks				
Barrier Type:	Cross Slope - Existing (5.0% or more)				
Code Ref:	CBC 1133B.7.1.3 and ADA/ABA 403.3

As Built Meas:	255	Quantity:	LF
Description:	Cross slope exceeds 2.0% (5.0% or more)		
As Built Desc:	5.3% cross slope		
Solution:	Demolish existing and construct new route		
Bar. Severity:	1 Necessary	Cost Estimate:	\$31,875.00
Implementation Priority:	4	Facility Function:	
Implementation Phase:		Implementation Date:	
Official Responsible:			
Notes:

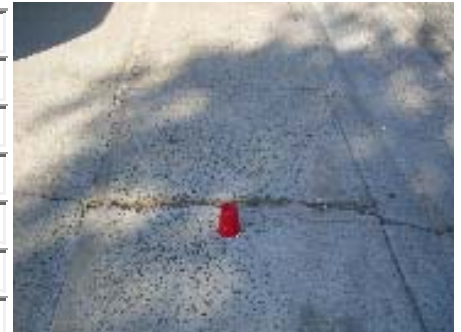
Field Date:	9/30/2010	Report Date:	9/30/2010	Barrier #:	87B
Location:	Whyte Ave - South				
X Coordinate:	-121.30216				
Y Coordinate:	38.72129				
Barrier Area:	Sidewalks				
Barrier Type:	Surface Condition - Damaged				
Code Ref:	CBC 1133B.7.1 and ADA/ABA 302.1

As Built Meas:	4	Quantity:	LF
Description:	Surface is not firm and stable (cracked, broken or loose soil, etc.)		
As Built Desc:	Cracked concrete		
Solution:	Repair surface to make firm and stable		
Bar. Severity:	1 Necessary	Cost Estimate:	\$500.00
Implementation Priority:	4	Facility Function:	
Implementation Phase:		Implementation Date:	
Official Responsible:			
Notes:

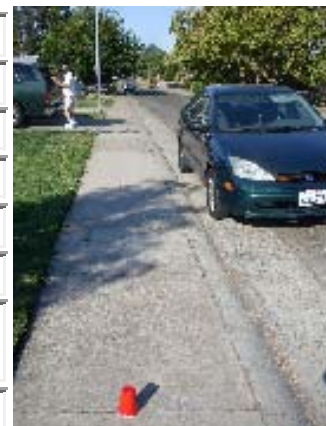
Field Date:	9/30/2010	Report Date:	9/30/2010	Barrier #:	88
Location:	Whyte Ave - South				
X Coordinate:	-121.30243				
Y Coordinate:	38.72129				
Barrier Area:	Sidewalks				
Barrier Type:	Cross Slope - Existing (4.1% to 4.9%)				
Code Ref:	CBC 1133B.7.1.3 and ADA/ABA 403.3

As Built Meas:	325	Quantity:	LF
Description:	Cross slope exceeds 2.0% (4.1% to 4.9%)		
As Built Desc:	4.7% cross slope		
Solution:	Demolish existing and construct new route		
Bar. Severity:	2 Recommended	Cost Estimate:	\$40,625.00
Implementation Priority:	4	Facility Function:	
Implementation Phase:		Implementation Date:	
Official Responsible:			
Notes:

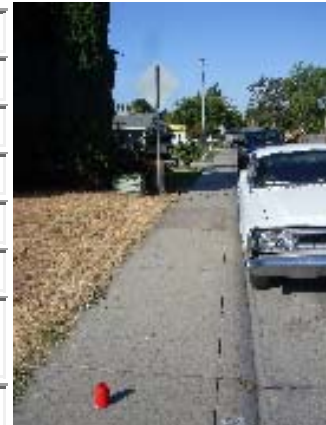
Barrier Type: Cross Slope - Existing (5.0% or more)

Description: Cross slope exceeds 2.0% (5.0% or more)

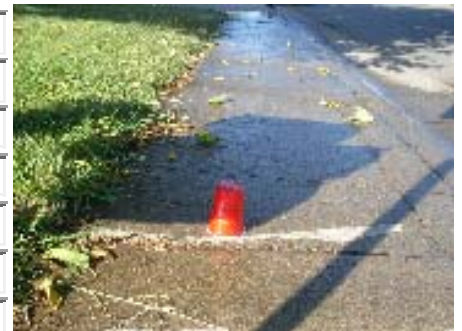
Barrier Type: Abrupt Change in Level - > 1/2"

Description: Change in level greater than 1/2"

Solution: Grind or repair sidewalk to remove trip hazard

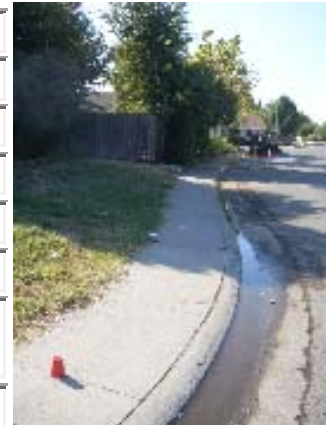
Barrier Type: Cross Slope - Existing (5.0% or more)

Description: Cross slope exceeds 2.0% (5.0% or more)
