DRAFT ADA TRANSITION PLAN UPDATE
NEIGHBORHOOD AREA 1 NORTHWEST
SEPTEMBER 20, 2011

CITY OF CITRUS HEIGHTS

The Northwest Neighborhood Association

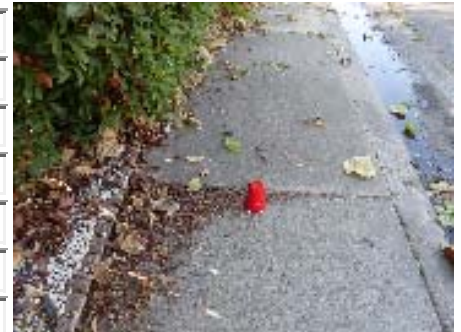
Field Date:	9/30/2010	Report Date:	9/30/2010	Barrier #:	90C
Location:	Lichen Dr - East				
X Coordinate:	-121.30499				
Y Coordinate:	38.72101				
Barrier Area:	Sidewalks				
Barrier Type:	Abrupt Change in Level - > 1/2"				
Code Ref:	CBC 1133B.7.1 and ADA/ABA 303.3

As Built Meas:	4	Quantity:	LF
Description:	Change in level greater than 1/2"		
As Built Desc:	1" lip in sidewalk surface		
Solution:	Grind or repair to remove trip hazard		
Bar. Severity:	1 Necessary	Cost Estimate:	\$1,000.00
Implementation Priority:	2	Facility Function:	
Implementation Phase:		Implementation Date:	
Official Responsible:			
Notes:

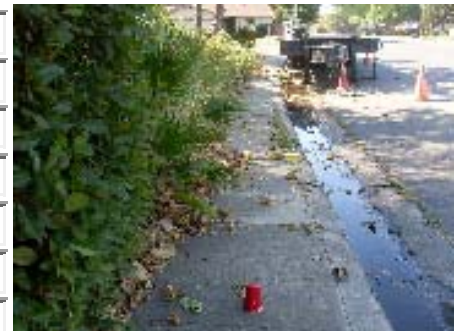
Field Date:	9/30/2010	Report Date:	9/30/2010	Barrier #:	90D
Location:	Lichen Dr - East				
X Coordinate:	-121.30501				
Y Coordinate:	38.72102				
Barrier Area:	Sidewalks				
Barrier Type:	Clear Width - Existing ($\leq 31"$ or less)				
Code Ref:	CBC 1133B.7.1

As Built Meas:	1	Quantity:	LF
Description:	Pedestrian route is not min. 48" wide ($\leq 31"$ or less)		
As Built Desc:	28" clear width due to foliage		
Solution:	Trim foliage to provide min. 48" clear width		
Bar. Severity:	1 Necessary	Cost Estimate:	\$125.00
Implementation Priority:	2	Facility Function:	
Implementation Phase:		Implementation Date:	
Official Responsible:			
Notes:

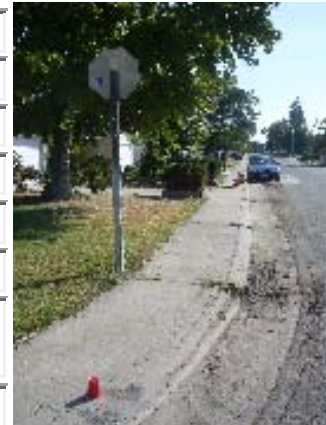
Barrier Type: Cross Slope - Existing (5.0% or more)

Description: Cross slope exceeds 2.0% (5.0% or more)

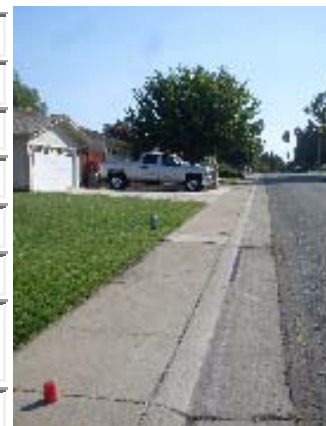
Barrier Type: Cross Slope - Existing (5.0% or more)

Description: Cross slope exceeds 2.0% (5.0% or more)

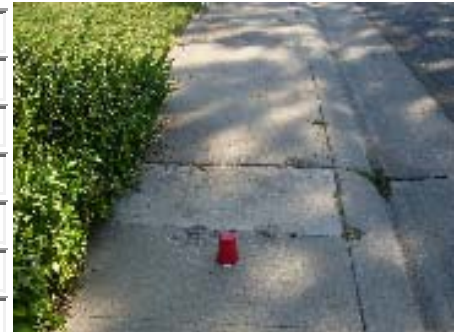
Barrier Type: Surface Condition - Damaged

Description: Surface is not firm and stable (cracked, broken or loose soil, etc.)

As Built Desc: Cracked concrete

Solution: Repair surface to make firm and stable

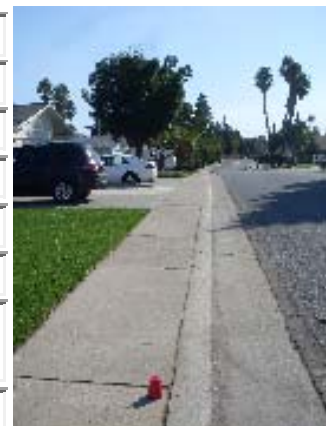
Barrier Type: Cross Slope - Existing (5.0% or more)

Description: Cross slope exceeds 2.0% (5.0% or more)

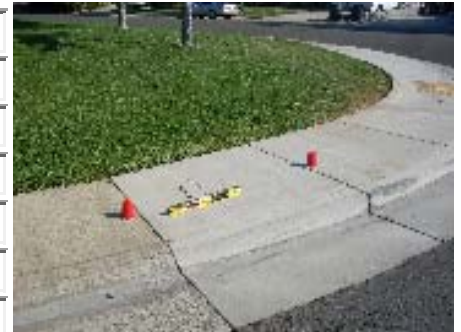
Field Date:	9/30/2010	Report Date:	9/30/2010	Barrier #:	94
Location:	Blue Springs Wy - North				
X Coordinate:	-121.30034				
Y Coordinate:	38.72053				
Barrier Area:	Sidewalks				
Barrier Type:	Running Slope (Existing)				
Code Ref:	CBC 1133B.7.3 and ADA/ABA 403.3

As Built Meas:	4	Quantity:	LF
Description:	Running slope exceeds 5.0%		
As Built Desc:	6.9% running slope		
Solution:	No remediation where sidewalk sloped as roadway		
Bar. Severity:	5 Technically Infeasible	Cost Estimate:	\$0.00
Implementation Priority:	4	Facility Function:	
Implementation Phase:		Implementation Date:	
Official Responsible:			
Notes:

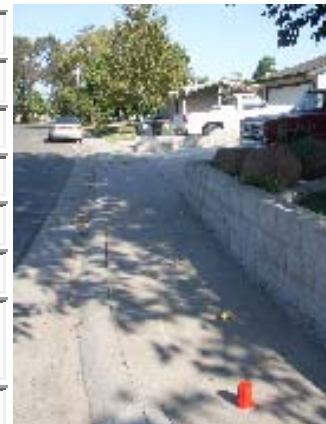
Field Date:	9/30/2010	Report Date:	9/30/2010	Barrier #:	95A
Location:	Mountainside Dr - East				
X Coordinate:	-121.30011				
Y Coordinate:	38.72067				
Barrier Area:	Sidewalks				
Barrier Type:	Cross Slope - Existing (5.0% or more)				
Code Ref:	CBC 1133B.7.1.3 and ADA/ABA 403.3

As Built Meas:	247	Quantity:	LF
Description:	Cross slope exceeds 2.0% (5.0% or more)		
As Built Desc:	5.5% cross slope		
Solution:	Demolish existing and construct new route		
Bar. Severity:	1 Necessary	Cost Estimate:	\$30,875.00
Implementation Priority:	4	Facility Function:	
Implementation Phase:		Implementation Date:	
Official Responsible:			
Notes:

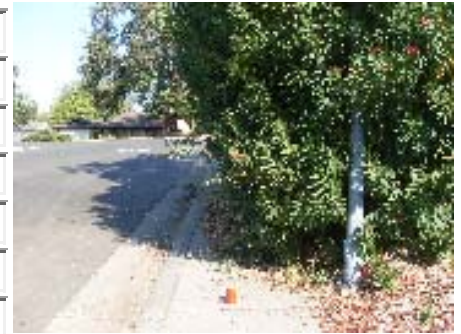
Field Date:	9/30/2010	Report Date:	9/30/2010	Barrier #:	95B
Location:	Mountainside Dr - East				
X Coordinate:	-121.30026				
Y Coordinate:	38.72101				
Barrier Area:	Sidewalks				
Barrier Type:	Clear Width - New Construction				
Code Ref:	CBC 1133B.7.1

As Built Meas:	1	Quantity:	LF
Description:	Pedestrian route is not min. 48" wide		
As Built Desc:	0" clear width due to foilage growth		
Solution:	Trim foliage to provide min. 48" clear width		
Bar. Severity:	1 Necessary	Cost Estimate:	\$125.00
Implementation Priority:	4	Facility Function:	
Implementation Phase:		Implementation Date:	
Official Responsible:			
Notes:

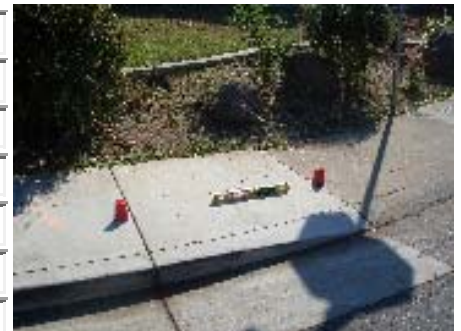
Field Date:	9/30/2010	Report Date:	9/30/2010	Barrier #:	96
Location:	Mountainside Dr - East				
X Coordinate:	-121.30036				
Y Coordinate:	38.72126				
Barrier Area:	Sidewalks				
Barrier Type:	Running Slope (New Construction)				
Code Ref:	CBC 1133B.7.3 and ADA/ABA 403.3

As Built Meas:	4	Quantity:	LF
Description:	Running slope exceeds 5.0% where roadway slope does not		
As Built Desc:	8.4% running slope		
Solution:	Demolish existing and construct new route		
Bar. Severity:	1 Necessary	Cost Estimate:	\$500.00
Implementation Priority:	4	Facility Function:	
Implementation Phase:		Implementation Date:	
Official Responsible:			
Notes:

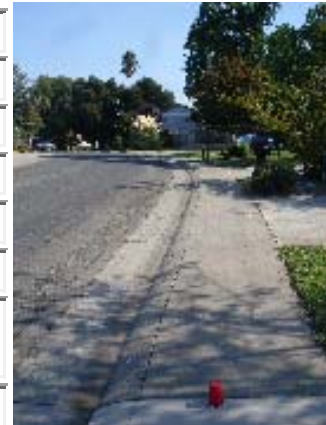
Barrier Type: Cross Slope - Existing (5.0% or more)

As Built Meas: 261 Quantity: LF

Description: Cross slope exceeds 2.0% (5.0% or more)

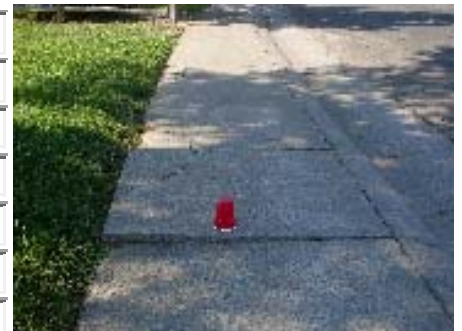
Barrier Type: Abrupt Change in Level - > 1/2"

As Built Meas: 4 Quantity: LF

Description: Change in level greater than 1/2"

Solution: Grind or repair sidewalk to remove trip hazard

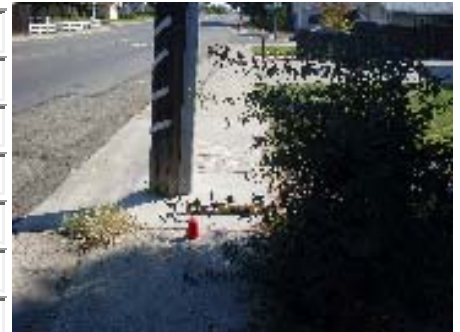
Field Date:	9/30/2010	Report Date:	9/30/2010	Barrier #:	98C
Location:	Whyte Ave - South				
X Coordinate:	-121.29948				
Y Coordinate:	38.72199				
Barrier Area:	Sidewalks				
Barrier Type:	Clear Width - New Construction				
Code Ref:	CBC 1133B.7.1

As Built Meas:	4	Quantity:	LF
Description:	Pedestrian route is not min. 48" wide		
As Built Desc:	24" clear width due to pole and foliage		
Solution:	Make alterations to provide min.. 32" clear width		
Bar. Severity:	1 Necessary	Cost Estimate:	\$500.00
Implementation Priority:	4	Facility Function:	
Implementation Phase:		Implementation Date:	
Official Responsible:			
Notes:

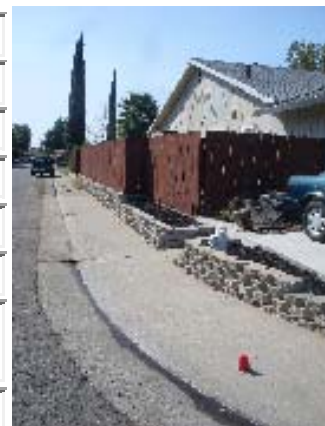
Field Date:	9/30/2010	Report Date:	9/30/2010	Barrier #:	99
Location:	Blue Springs Wy - West				
X Coordinate:	-121.29900				
Y Coordinate:	38.72194				
Barrier Area:	Sidewalks				
Barrier Type:	Cross Slope - Existing (5.0% or more)				
Code Ref:	CBC 1133B.7.1.3 and ADA/ABA 403.3

As Built Meas:	198	Quantity:	LF
Description:	Cross slope exceeds 2.0% (5.0% or more)		
As Built Desc:	5.6% cross slope		
Solution:	Demolish existing and construct new route		
Bar. Severity:	1 Necessary	Cost Estimate:	\$24,750.00
Implementation Priority:	4	Facility Function:	
Implementation Phase:		Implementation Date:	
Official Responsible:			
Notes:

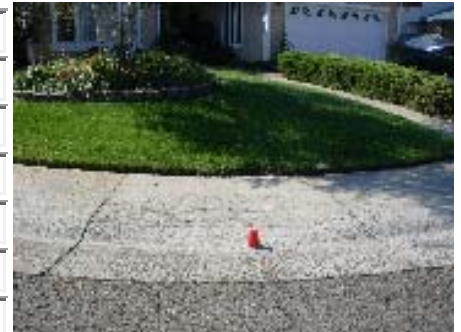
Barrier Type: No Curb Ramp - Depressed Existing Curb

As Built Meas: 1 Quantity: EACH

Description: No compliant curb cut at corner (intersection)

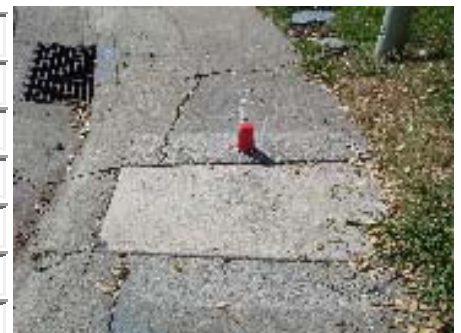
Barrier Type: Abrupt Change in Level - > 1/2"

As Built Meas: 4 Quantity: LF

Description: Change in level greater than 1/2"

Solution: Grind or repair sidewalk to remove trip hazard

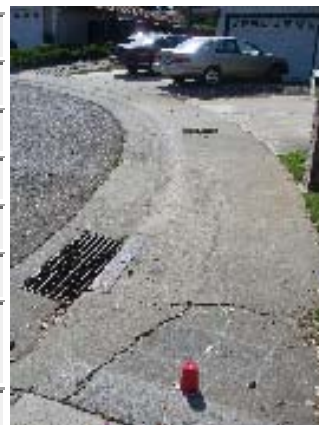
Barrier Type: Cross Slope - Existing (4.1% to 4.9%)

As Built Meas: 111 Quantity: LF

Description: Cross slope exceeds 2.0% (4.1% to 4.9%)

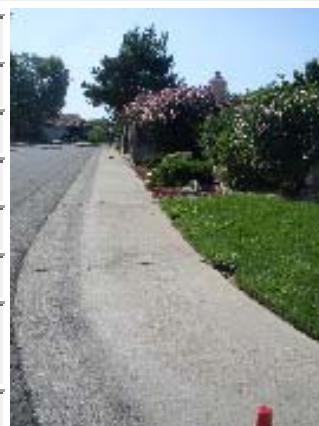
Barrier Type: Cross Slope - Existing (5.0% or more)

As Built Meas: 195 Quantity: LF

Description: Cross slope exceeds 2.0% (5.0% or more)

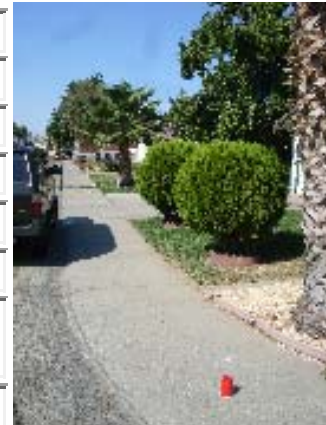
Field Date:	9/30/2010	Report Date:	9/30/2010	Barrier #:	104
Location:	Blue Springs Wy - North				
X Coordinate:	-121.29918				
Y Coordinate:	38.72060				
Barrier Area:	Sidewalks				
Barrier Type:	Cross Slope - Existing (5.0% or more)				
Code Ref:	CBC 1133B.7.1.3 and ADA/ABA 403.3

As Built Meas:	269	Quantity:	LF
Description:	Cross slope exceeds 2.0% (5.0% or more)		
As Built Desc:	6.4% cross slope		
Solution:	Demolish existing and construct new route		
Bar. Severity:	1 Necessary	Cost Estimate:	\$33,625.00
Implementation Priority:	4	Facility Function:	
Implementation Phase:		Implementation Date:	
Official Responsible:			
Notes:

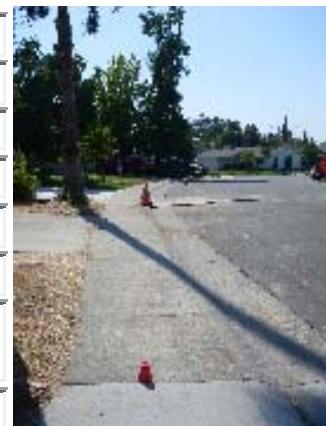
Field Date:	9/30/2010	Report Date:	9/30/2010	Barrier #:	105
Location:	Mountainside Dr - East				
X Coordinate:	-121.30010				
Y Coordinate:	38.72042				
Barrier Area:	Sidewalks				
Barrier Type:	Cross Slope - Existing (5.0% or more)				
Code Ref:	CBC 1133B.7.1.3 and ADA/ABA 403.3

As Built Meas:	191	Quantity:	LF
Description:	Cross slope exceeds 2.0% (5.0% or more)		
As Built Desc:	5.5% cross slope		
Solution:	Demolish existing and construct new route		
Bar. Severity:	1 Necessary	Cost Estimate:	\$23,875.00
Implementation Priority:	4	Facility Function:	
Implementation Phase:		Implementation Date:	
Official Responsible:			
Notes:

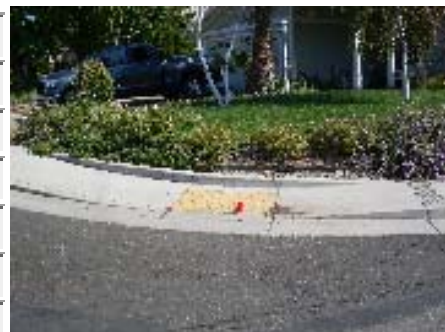
Barrier Type: Perpendicular Ramp Landing - New Construction

As Built Meas: 1 Quantity: EACH

Description: Curb ramp landing or pan not level (>5.0% or more)

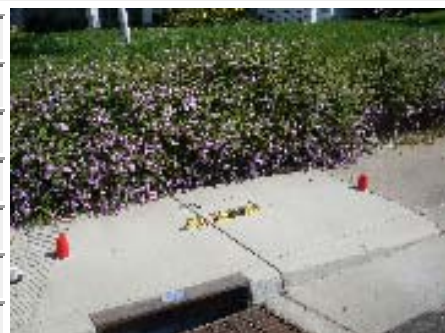
Barrier Type: Running Slope (New Construction)

As Built Meas: 7 Quantity: LF

Description: Running slope exceeds 5.0% where roadway slope does not

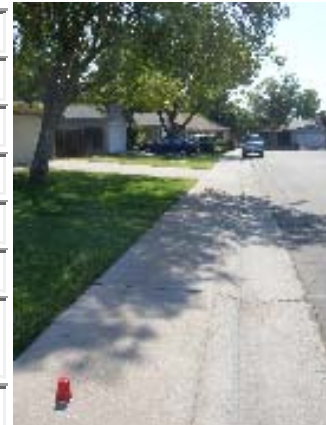
Barrier Type: Cross Slope - Existing (4.1% to 4.9%)

As Built Meas: 250 Quantity: LF

Description: Cross slope exceeds 2.0% (4.1% to 4.9%)

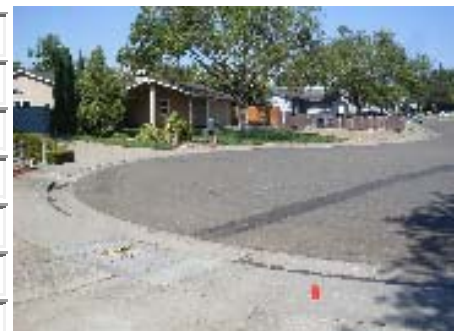
Barrier Type: Cross Slope - Existing (4.1% to 4.9%)

As Built Meas: 463 Quantity: LF

Description: Cross slope exceeds 2.0% (4.1% to 4.9%)

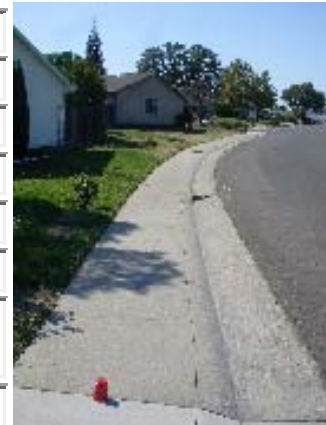
Barrier Type: Cross Slope - Existing (4.1% to 4.9%)

As Built Meas: 149 Quantity: LF

Description: Cross slope exceeds 2.0% (4.1% to 4.9%)

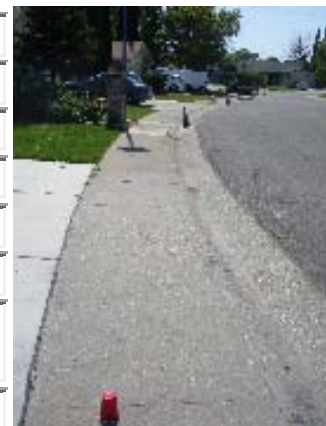
Barrier Type: Cross Slope - Existing (4.1% to 4.9%)

As Built Meas: 434 Quantity: LF

Description: Cross slope exceeds 2.0% (4.1% to 4.9%)

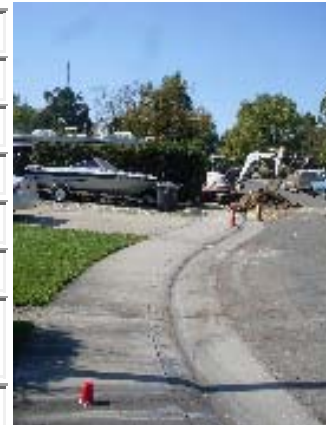
Barrier Type: Cross Slope - Existing (3.1% to 4.0%)

As Built Meas: 176 Quantity: LF

Description: Cross slope exceeds 2.0% (3.1% to 4.0%)

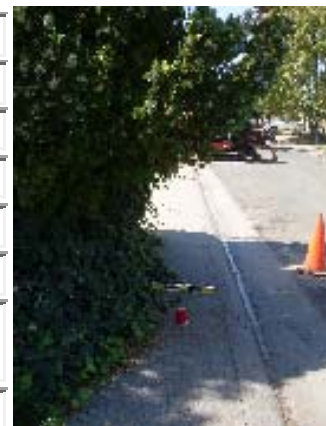
Barrier Type: Clear Width - New Construction

As Built Meas: 1 Quantity: LF

Description: Pedestrian route is not min. 48" wide

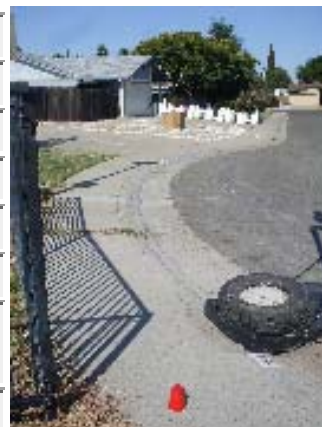
Barrier Type: Cross Slope - Existing (4.1% to 4.9%)

As Built Meas: 227 Quantity: LF

Description: Cross slope exceeds 2.0% (4.1% to 4.9%)

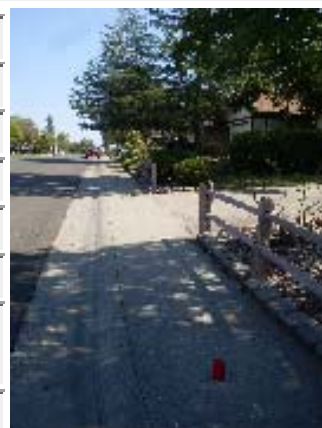
Barrier Type: Cross Slope - Existing (5.0% or more)

As Built Meas: 898 Quantity: LF

Description: Cross slope exceeds 2.0% (5.0% or more)

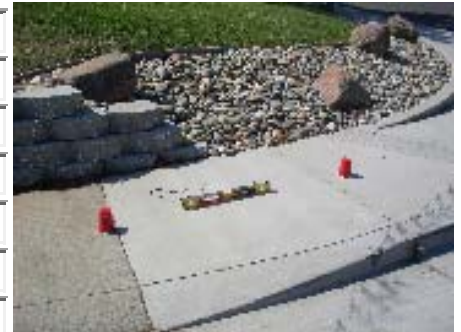
Field Date:	9/30/2010	Report Date:	9/30/2010	Barrier #:	118
Location:	Canevalley Cir - West				
X Coordinate:	-121.30115				
Y Coordinate:	38.71948				
Barrier Area:	Sidewalks				
Barrier Type:	Running Slope (New Construction)				
Code Ref:	CBC 1133B.7.3 and ADA/ABA 403.3

As Built Meas:	4	Quantity:	LF
Description:	Running slope exceeds 5.0% where roadway slope does not		
As Built Desc:	7.1% running slope		
Solution:	Demolish existing and construct new route		
Bar. Severity:	1 Necessary	Cost Estimate:	\$500.00
Implementation Priority:	4	Facility Function:	
Implementation Phase:		Implementation Date:	
Official Responsible:			
Notes:

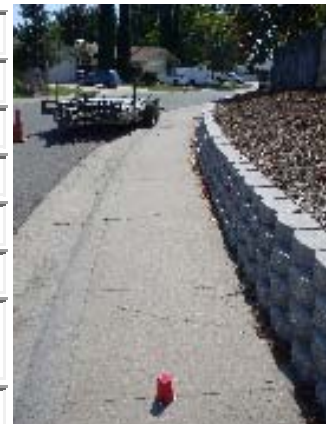
Field Date:	9/30/2010	Report Date:	9/30/2010	Barrier #:	119
Location:	Canevalley Cir - West				
X Coordinate:	-121.30111				
Y Coordinate:	38.71946				
Barrier Area:	Sidewalks				
Barrier Type:	Cross Slope - Existing (3.1% to 4.0%)				
Code Ref:	CBC 1133B.7.1.3 and ADA/ABA 403.3

As Built Meas:	264	Quantity:	LF
Description:	Cross slope exceeds 2.0% (3.1% to 4.0%)		
As Built Desc:	3.9% cross slope		
Solution:	Demolish existing and construct new route		
Bar. Severity:	3 Hindrance	Cost Estimate:	\$33,000.00
Implementation Priority:	4	Facility Function:	
Implementation Phase:		Implementation Date:	
Official Responsible:			
Notes:

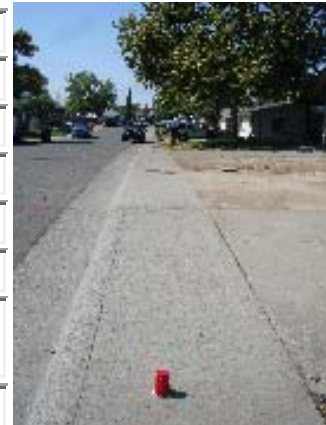
Field Date:	9/30/2010	Report Date:	9/30/2010	Barrier #:	122A
Location:	Canevalley Cir - North				
X Coordinate:	-121.30268				
Y Coordinate:	38.71873				
Barrier Area:	Sidewalks				
Barrier Type:	Cross Slope - Existing (5.0% or more)				
Code Ref:	CBC 1133B.7.1.3 and ADA/ABA 403.3				
As Built Meas:	495	Quantity:	LF		
Description:	Cross slope exceeds 2.0% (5.0% or more)				
As Built Desc:	5.1% cross slope				
Solution:	Demolish existing and construct new route				
Bar. Severity:	1 Necessary	Cost Estimate:	\$61,875.00	Status:	
Implementation Priority:	4	Facility Function:			
Implementation Phase:		Implementation Date:			
Official Responsible:

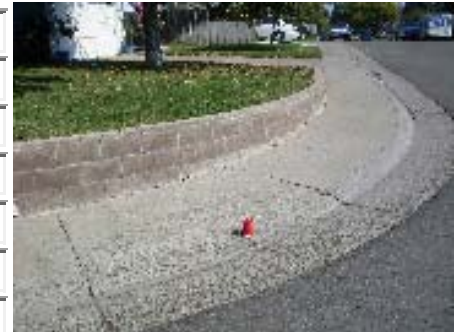
Field Date:	9/30/2010	Report Date:	9/30/2010	Barrier #:	123
Location:	Canevalley Cir - North				
X Coordinate:	-121.30437				
Y Coordinate:	38.71875				
Barrier Area:	Sidewalks				
Barrier Type:	Elbow in Sidewalk - Cross Slope (5.0% or more)				
Code Ref:	CBC 1133B.7.1.3 and ADA/ABA 403.3

As Built Meas:	4	Quantity:	LF
Description:	Cross slope at elbow exceeds 2.0% (5.0% or more)		
As Built Desc:	12.1% cross slope		
Solution:	Demolish existing and construct new sidewalk without curb ramp		
Bar. Severity:	1 Necessary	Cost Estimate:	\$500.00
Implementation Priority:	4	Facility Function:	
Implementation Phase:		Implementation Date:	
Official Responsible:			
Notes:

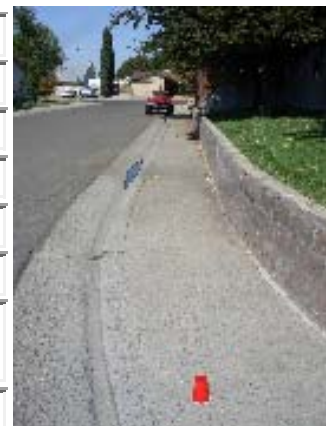
Field Date:	9/30/2010	Report Date:	9/30/2010	Barrier #:	124
Location:	Canevalley Cir - East				
X Coordinate:	-121.30442				
Y Coordinate:	38.71881				
Barrier Area:	Sidewalks				
Barrier Type:	Cross Slope - Existing (4.1% to 4.9%)				
Code Ref:	CBC 1133B.7.1.3 and ADA/ABA 403.3

As Built Meas:	179	Quantity:	LF
Description:	Cross slope exceeds 2.0% (4.1% to 4.9%)		
As Built Desc:	4.4% cross slope		
Solution:	Demolish existing and construct new route		
Bar. Severity:	2 Recommended	Cost Estimate:	\$22,375.00
Implementation Priority:	4	Facility Function:	
Implementation Phase:		Implementation Date:	
Official Responsible:			
Notes:

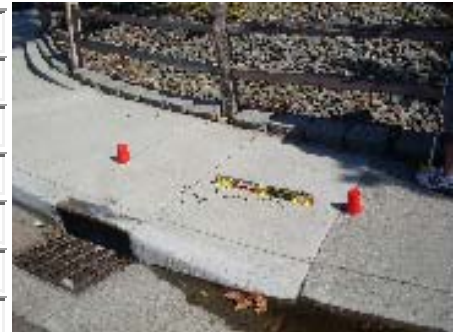
Field Date:	9/30/2010	Report Date:	9/30/2010	Barrier #:	125
Location:	Canevalley Cir - East				
X Coordinate:	-121.30442				
Y Coordinate:	38.71922				
Barrier Area:	Sidewalks				
Barrier Type:	Running Slope (New Construction)				
Code Ref:	CBC 1133B.7.3 and ADA/ABA 403.3

As Built Meas:	4	Quantity:	LF
Description:	Running slope exceeds 5.0% where roadway slope does not		
As Built Desc:	7.9% running slope		
Solution:	Demolish existing and construct new route		
Bar. Severity:	1 Necessary	Cost Estimate:	\$500.00
Implementation Priority:	4	Facility Function:	
Implementation Phase:		Implementation Date:	
Official Responsible:			
Notes:

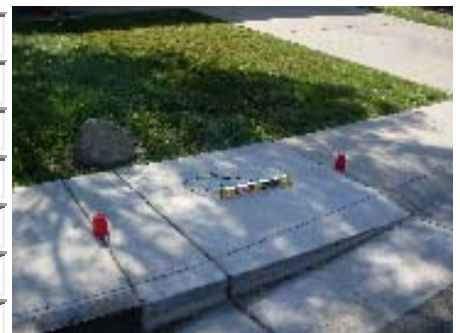
Field Date:	9/30/2010	Report Date:	9/30/2010	Barrier #:	126
Location:	Mountainside Dr - South				
X Coordinate:	-121.30465				
Y Coordinate:	38.71932				
Barrier Area:	Sidewalks				
Barrier Type:	Running Slope (New Construction)				
Code Ref:	CBC 1133B.7.3 and ADA/ABA 403.3

As Built Meas:	4	Quantity:	LF
Description:	Running slope exceeds 5.0% where roadway slope does not		
As Built Desc:	8.0% running slope		
Solution:	Demolish existing and construct new route		
Bar. Severity:	1 Necessary	Cost Estimate:	\$500.00
Implementation Priority:	4	Facility Function:	
Implementation Phase:		Implementation Date:	
Official Responsible:			
Notes:

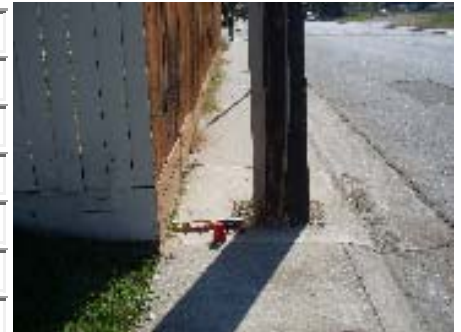
Field Date:	9/30/2010	Report Date:	9/30/2010	Barrier #:	128B
Location:	Lichen Dr - East				
X Coordinate:	-121.30530				
Y Coordinate:	38.71835				
Barrier Area:	Sidewalks				
Barrier Type:	Clear Width - New Construction				
Code Ref:	CBC 1133B.7.1

As Built Meas:	18	Quantity:	LF
Description:	Pedestrian route is not min. 48" wide		
As Built Desc:	24" clear width due to pole and guide wire		
Solution:	Make alterations to provide min.. 32" clear width		
Bar. Severity:	1 Necessary	Cost Estimate:	\$2,250.00
Implementation Priority:	2	Facility Function:	
Implementation Phase:		Implementation Date:	
Official Responsible:

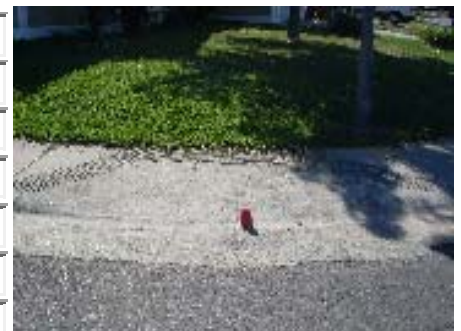
Field Date:	10/1/2010	Report Date:	10/1/2010	Barrier #:	129
Location:	Lichen Dr and Cloverleaf Wy - Corner C				
X Coordinate:	-121.30526				
Y Coordinate:	38.71795				
Barrier Area:	Curb Ramps				
Barrier Type:	No Curb Ramp - Depressed Existing Curb				
Code Ref:	CBC 1127B.5.1 and ADA/ABA 402.2

As Built Meas:	1	Quantity:	EACH
Description:	No compliant curb cut at corner (intersection)		
As Built Desc:	9.8% running slope at depressed area		
Solution:	Demolish existing and construct curb cut		
Bar. Severity:	1 Necessary	Cost Estimate:	\$2,500.00
Implementation Priority:	2	Facility Function:	
Implementation Phase:		Implementation Date:	
Official Responsible:

Notes:	Three - way intersection corners A,B,C. Corners A,B compliant
--------	---

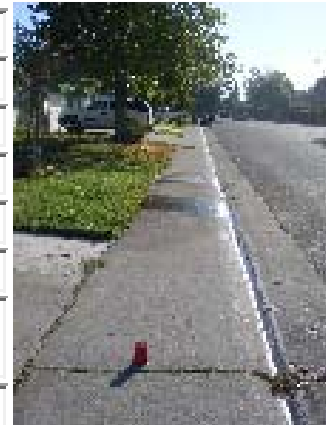
Barrier Type: Cross Slope - Existing (5.0% or more)

As Built Meas: 512 Quantity: LF

Description: Cross slope exceeds 2.0% (5.0% or more)

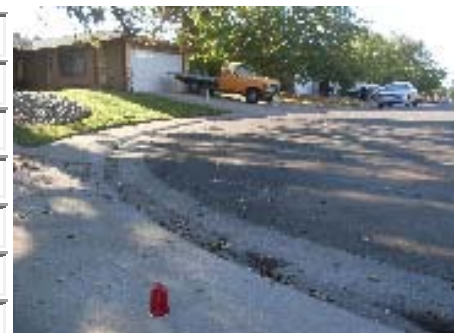
Barrier Type: Cross Slope - Existing (3.1% to 4.0%)

As Built Meas: 93 Quantity: LF

Description: Cross slope exceeds 2.0% (3.1% to 4.0%)

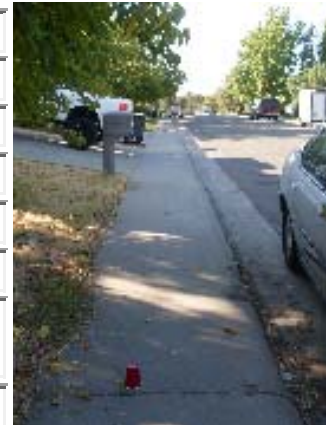
Barrier Type: Cross Slope - Existing (4.1% to 4.9%)

As Built Meas: 610 Quantity: LF

Description: Cross slope exceeds 2.0% (4.1% to 4.9%)

Bar. Severity: 2 Recommended

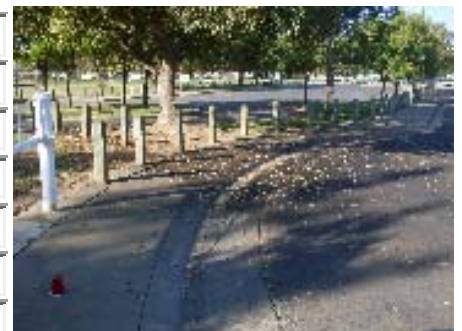
Barrier Type: Cross Slope - Existing (5.0% or more)

As Built Meas: 51 Quantity: LF

Description: Cross slope exceeds 2.0% (5.0% or more)

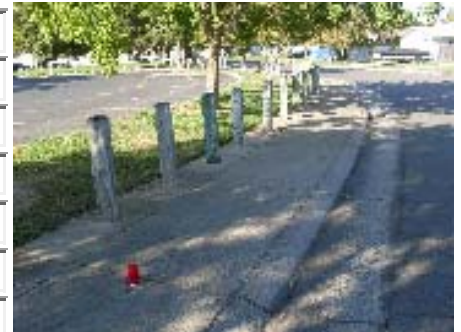
Barrier Type: Cross Slope - Existing (5.0% or more)

As Built Meas: 121 Quantity: LF

Description: Cross slope exceeds 2.0% (5.0% or more)

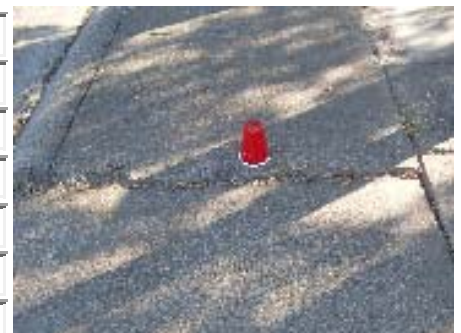
Barrier Type: Abrupt Change in Level - > 1/2"

As Built Meas: 4 Quantity: LF

Description: Change in level greater than 1/2"

Solution: Grind or repair to remove trip hazard

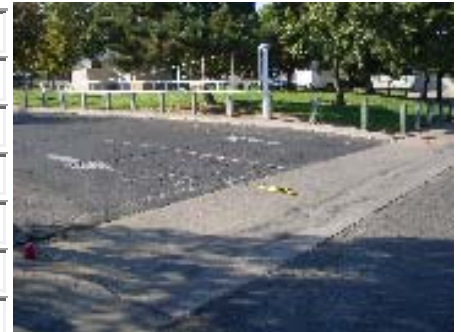
Barrier Type: Driveway - New Construction

As Built Meas: 35 Quantity: LF

Description: Driveway cross/running slope exceeds 2.0%

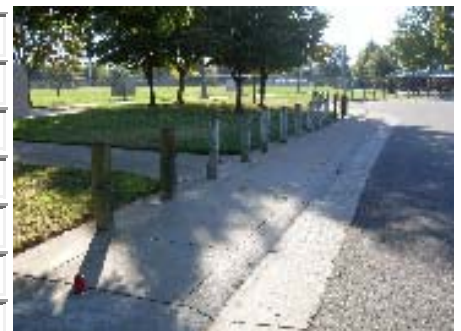
Barrier Type: Cross Slope - Existing (5.0% or more)

As Built Meas: 83 Quantity: LF

Description: Cross slope exceeds 2.0% (5.0% or more)

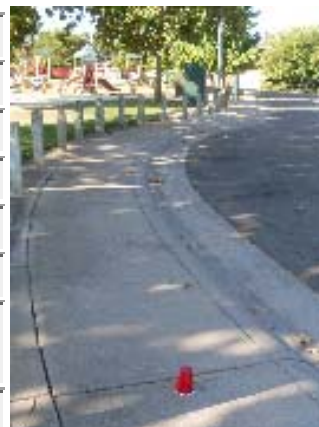
Barrier Type: Cross Slope - Existing (4.1% to 4.9%)

As Built Meas: 90 Quantity: LF

Description: Cross slope exceeds 2.0% (4.1% to 4.9%)

Bar. Severity: 2 Recommended

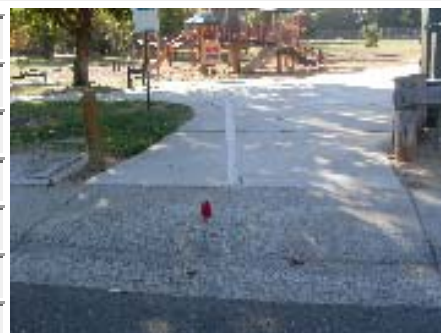
Barrier Type: Elbow in Sidewalk - Cross Slope (5.0% or more)

As Built Meas: 8 Quantity: LF

Description: Cross slope at elbow exceeds 2.0% (5.0% or more)

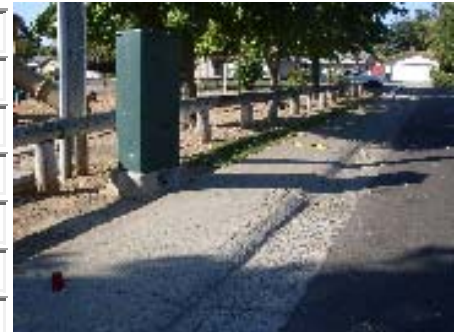
Barrier Type: Cross Slope - Existing (5.0% or more)

As Built Meas: 95 Quantity: LF

Description: Cross slope exceeds 2.0% (5.0% or more)

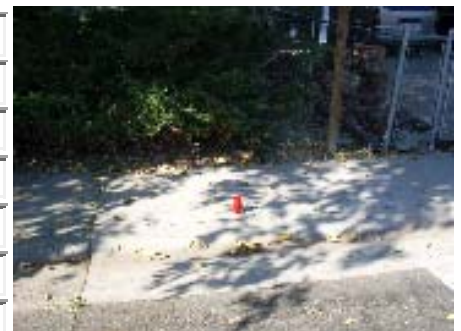
Barrier Type: No Curb Ramp

As Built Meas: 1 Quantity: EACH

Description: No curb cut at corner (intersection)

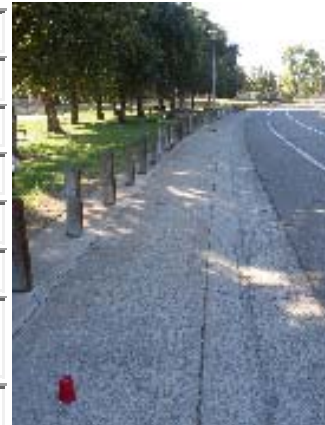
Barrier Type: Cross Slope - Existing (4.1% to 4.9%)

As Built Meas: 201 Quantity: LF

Description: Cross slope exceeds 2.0% (4.1% to 4.9%)

Bar. Severity: 2 Recommended Cost Estimate: \$25,125.00 Status:

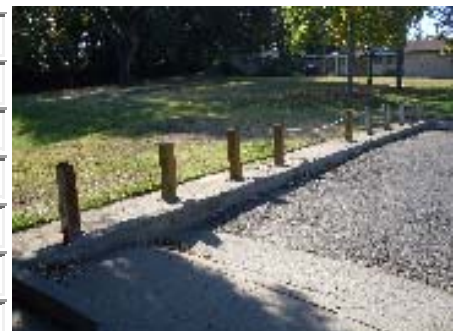
Barrier Type: Continuous Surface

As Built Meas: 42 Quantity: LF

Description: Sidewalks lack a continuous common surface

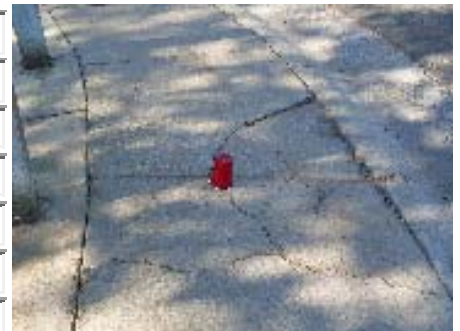
Field Date:	10/1/2010	Report Date:	10/1/2010	Barrier #:	142B
Location:	Butternut Dr - East				
X Coordinate:	-121.30447				
Y Coordinate:	38.71374				
Barrier Area:	Sidewalks				
Barrier Type:	Surface Condition - Damaged				
Code Ref:	CBC 1133B.7.1 and ADA/ABA 302.1

As Built Meas:	4	Quantity:	LF
Description:	Surface is not firm and stable (cracked, broken or loose soil, etc.)		
As Built Desc:	Cracked concrete		
Solution:	Repair surface to make firm and stable		
Bar. Severity:	1 Necessary	Cost Estimate:	\$500.00
Implementation Priority:	2	Facility Function:	
Implementation Phase:		Implementation Date:	
Official Responsible:			
Notes:

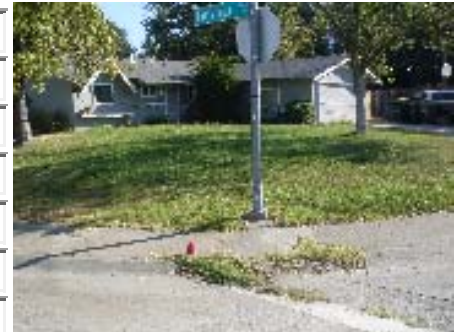
Barrier Type: No Curb Ramp

As Built Meas: 1 Quantity: EACH

Description: No curb cut at corner (intersection)

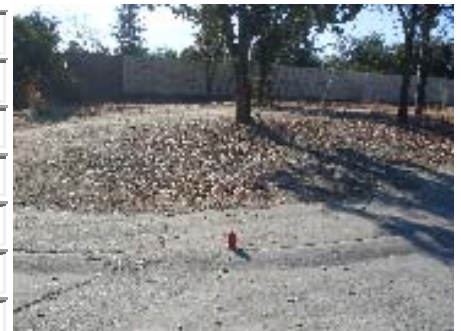
Barrier Type: No Curb Ramp

As Built Meas: 1 Quantity: EACH

Description: No curb cut at corner (intersection)

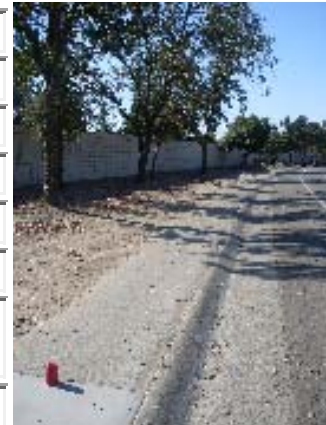
Barrier Type: Cross Slope - Existing (4.1% to 4.9%)

As Built Meas: 1054 Quantity: LF

Description: Cross slope exceeds 2.0% (4.1% to 4.9%)

Bar. Severity: 2 Recommended

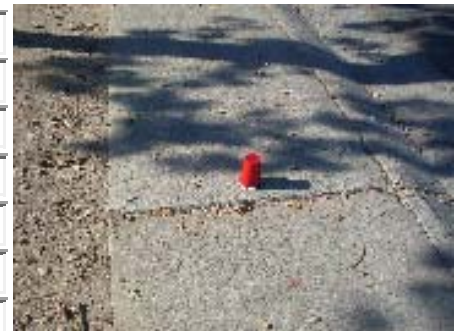
Barrier Type: Abrupt Change in Level - > 1/2"

As Built Meas: 4 Quantity: LF

Description: Change in level greater than 1/2"

Solution: Grind or repair to remove trip hazard

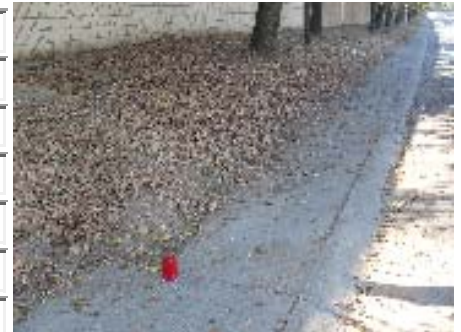
Barrier Type: Surface Condition - Damaged

As Built Meas: 4 Quantity: LF

Description: Surface is not firm and stable (cracked, broken or loose soil, etc.)

As Built Desc: Cracked concrete

Solution: Repair surface to make firm and stable

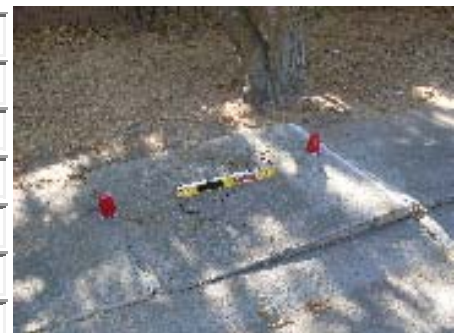
Barrier Type: Running Slope (New Construction)

As Built Meas: 4 Quantity: LF

Description: Running slope exceeds 5.0% where roadway slope does not

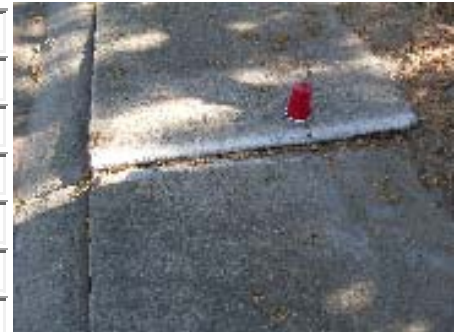
Barrier Type: Abrupt Change in Level - Tree Heaves

As Built Meas: 4 Quantity: LF

Description: Change in level greater than 1/2"

Solution: Grind or repair sidewalk to remove trip hazard

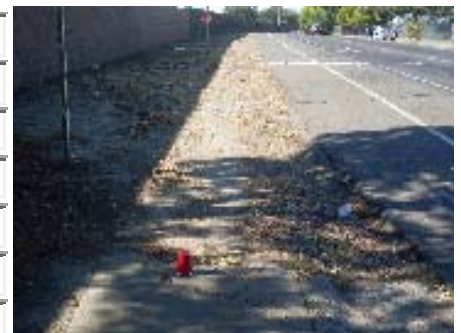
Barrier Type: No Sidewalk - Transition to Shoulder

As Built Meas: 1 Quantity: JOB

Description: Sidewalk ends and no ramp to pedestrian shoulder is provided

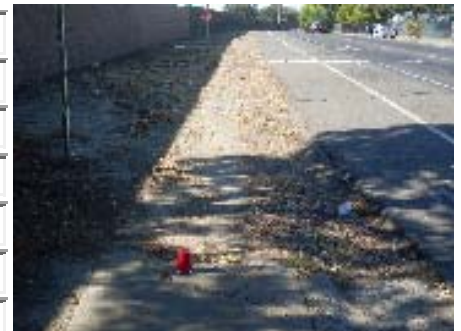
Field Date:	10/1/2010	Report Date:	10/1/2010	Barrier #:	145H
Location:	Butternut Dr - East				
X Coordinate:	-121.30696				
Y Coordinate:	38.71041				
Barrier Area:	Sidewalks				
Barrier Type:	Shoulder Cross Slope - Existing (2.1% to 3.0%)				
Code Ref:	CBC 1133B.7.1.3 and ADA/ABA 403.3

As Built Meas:	1056	Quantity:	LF
Description:	Cross slope exceeds 2.0% (2.1% to 3.0%)		
As Built Desc:	2.9% cross slope		
Solution:	Low severity barrier - no remediation recommended		
Bar. Severity:	4 Low Severity	Cost Estimate:	\$0.00
Implementation Priority:	2	Facility Function:	
Implementation Phase:		Implementation Date:	
Official Responsible:			
Notes:

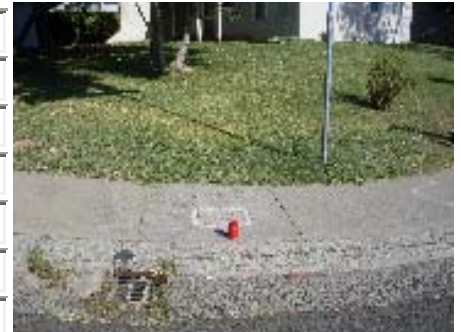
Field Date:	10/1/2010	Report Date:	10/1/2010	Barrier #:	146
Location:	Lichen Dr and Lichen Dr - Corner A				
X Coordinate:	-121.30711				
Y Coordinate:	38.71056				
Barrier Area:	Curb Ramps				
Barrier Type:	No Curb Ramp				
Code Ref:	CBC 1127B.5.1 and ADA/ABA 402.2

As Built Meas:	1	Quantity:	EACH
Description:	No curb cut at corner (intersection)		
As Built Desc:	No curb ramp at corner		
Solution:	Demolish existing and construct curb cut		
Bar. Severity:	1 Necessary	Cost Estimate:	\$2,500.00
Implementation Priority:	2	Facility Function:	
Implementation Phase:		Implementation Date:	
Official Responsible:			
Notes:	Three - way intersection corners A,B,D

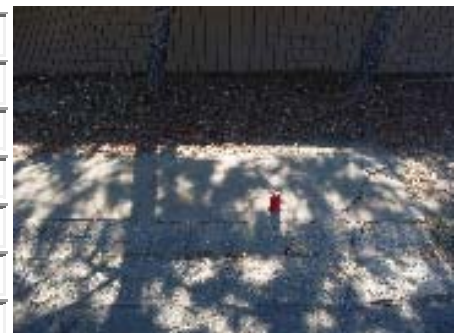
Field Date:	10/1/2010	Report Date:	10/1/2010	Barrier #:	147
Location:	Lichen Dr and Lichen Dr - Corner B				
X Coordinate:	-121.30702				
Y Coordinate:	38.71043				
Barrier Area:	Curb Ramps				
Barrier Type:	No Curb Ramp				
Code Ref:	CBC 1127B.5.1 and ADA/ABA 402.2

As Built Meas:	1	Quantity:	EACH
Description:	No curb cut at corner (intersection)		
As Built Desc:	No curb ramp at corner		
Solution:	Demolish existing and construct curb cut		
Bar. Severity:	1 Necessary	Cost Estimate:	\$2,500.00
Implementation Priority:	2	Facility Function:	
Implementation Phase:		Implementation Date:	
Official Responsible:			
Notes:	Three - way intersection corners A,B,D

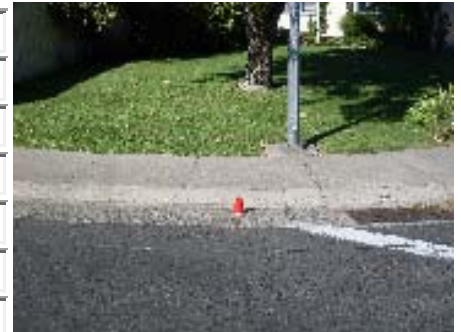
Field Date:	#####	Report Date:	10/12/2010	Barrier #:	148
Location:	Lichen Dr and Lichen Dr - Corner D				
X Coordinate:	-121.30721				
Y Coordinate:	38.71041				
Barrier Area:	Curb Ramps				
Barrier Type:	No Curb Ramp				
Code Ref:	CBC 1127B.5.1 and ADA/ABA 402.2

As Built Meas:	1	Quantity:	EACH
Description:	No curb cut at corner (intersection)		
As Built Desc:	No curb ramp at corner		
Solution:	Demolish existing and construct curb cut		
Bar. Severity:	1 Necessary	Cost Estimate:	\$2,500.00
Implementation Priority:	2	Facility Function:	
Implementation Phase:		Implementation Date:	
Official Responsible:			
Notes:	Three - way intersection corners A,B,D

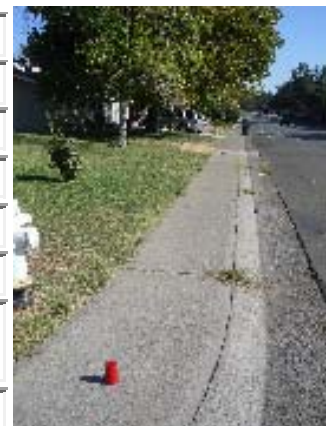
Field Date:	10/1/2010	Report Date:	10/1/2010	Barrier #:	149
Location:	Butternut Dr - West				
X Coordinate:	-121.30707				
Y Coordinate:	38.71057				
Barrier Area:	Sidewalks				
Barrier Type:	Cross Slope - Existing (5.0% or more)				
Code Ref:	CBC 1133B.7.1.3 and ADA/ABA 403.3

As Built Meas:	266	Quantity:	LF
Description:	Cross slope exceeds 2.0% (5.0% or more)		
As Built Desc:	5.6% cross slope		
Solution:	Demolish existing and construct new route		
Bar. Severity:	1 Necessary	Cost Estimate:	\$33,250.00
Implementation Priority:	2	Facility Function:	
Implementation Phase:		Implementation Date:	
Official Responsible:			
Notes:

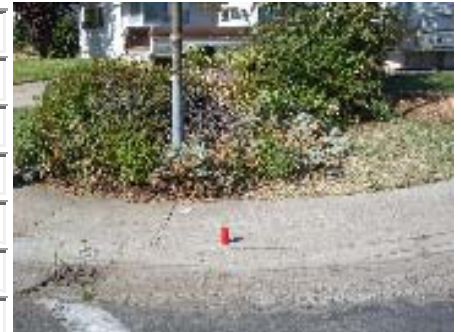
Field Date:	10/1/2010	Report Date:	10/1/2010	Barrier #:	150
Location:	Butternut Dr and Treelark Wy - Corner A				
X Coordinate:	-121.30645				
Y Coordinate:	38.71114				
Barrier Area:	Curb Ramps				
Barrier Type:	No Curb Ramp				
Code Ref:	CBC 1127B.5.1 and ADA/ABA 402.2

As Built Meas:	1	Quantity:	EACH
Description:	No curb cut at corner (intersection)		
As Built Desc:	No curb ramp at corner		
Solution:	Demolish existing and construct curb cut		
Bar. Severity:	1 Necessary	Cost Estimate:	\$2,500.00
Implementation Priority:	2	Facility Function:	
Implementation Phase:		Implementation Date:	
Official Responsible:			
Notes:	Two - way intersection corners A,B

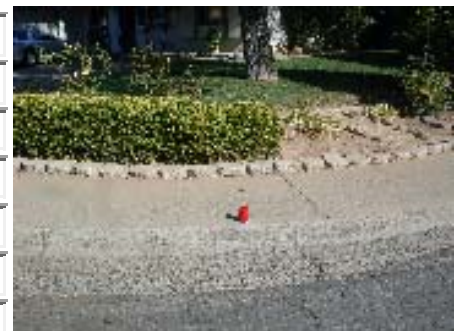
Field Date:	10/1/2010	Report Date:	10/1/2010	Barrier #:	151
Location:	Butternut Dr and Treelark Wy - Corner B				
X Coordinate:	-121.30630				
Y Coordinate:	38.71129				
Barrier Area:	Curb Ramps				
Barrier Type:	No Curb Ramp				
Code Ref:	CBC 1127B.5.1 and ADA/ABA 402.2

As Built Meas:	1	Quantity:	EACH
Description:	No curb cut at corner (intersection)		
As Built Desc:	No curb ramp at corner		
Solution:	Demolish existing and construct curb cut		
Bar. Severity:	1 Necessary	Cost Estimate:	\$2,500.00
Implementation Priority:	2	Facility Function:	
Implementation Phase:		Implementation Date:	
Official Responsible:			
Notes:	Two - way intersection corners A,B

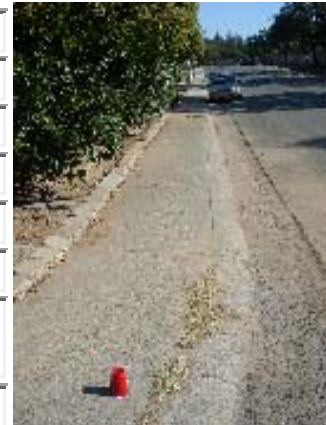
Barrier Type: Cross Slope - Existing (4.1% to 4.9%)

As Built Meas: 663 Quantity: LF

Description: Cross slope exceeds 2.0% (4.1% to 4.9%)

Bar. Severity: 2 Recommended

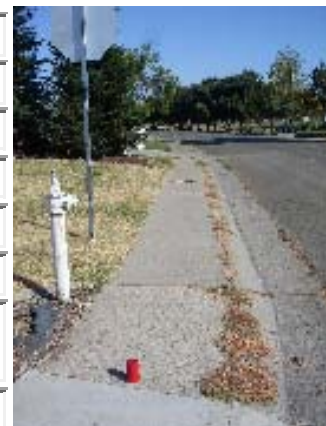
Barrier Type: Cross Slope - Existing (5.0% or more)

As Built Meas: 772 Quantity: LF

Description: Cross slope exceeds 2.0% (5.0% or more)

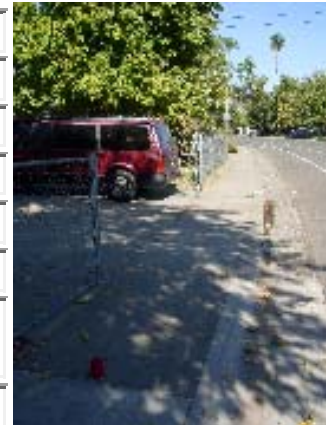
Barrier Type: Cross Slope - Existing (5.0% or more)

As Built Meas: 300 Quantity: LF

Description: Cross slope exceeds 2.0% (5.0% or more)

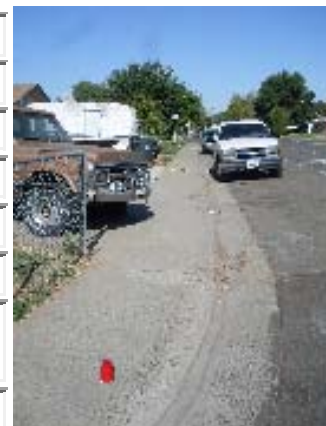
Barrier Type: Cross Slope - Existing (5.0% or more)

As Built Meas: 190 Quantity: LF

Description: Cross slope exceeds 2.0% (5.0% or more)

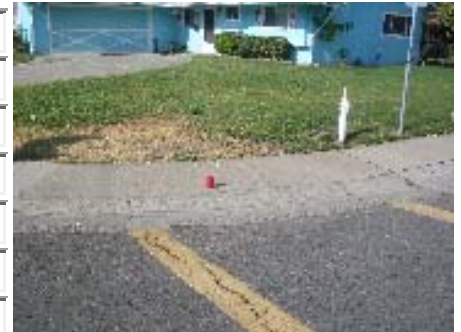
Field Date:	10/5/2010	Report Date:	10/5/2010	Barrier #:	156
Location:	Butternut Dr and Lichen Dr - Corner A (A-B)				
X Coordinate:	-121.30645				
Y Coordinate:	38.71632				
Barrier Area:	Curb Ramps				
Barrier Type:	No Curb Ramp				
Code Ref:	CBC 1127B.5.1 and ADA/ABA 402.2

As Built Meas:	1	Quantity:	EACH
Description:	No curb cut at corner (intersection)		
As Built Desc:	No curb ramp at corner		
Solution:	Demolish existing and construct curb cut		
Bar. Severity:	1 Necessary	Cost Estimate:	\$2,500.00
Implementation Priority:	2	Facility Function:	
Implementation Phase:		Implementation Date:	
Official Responsible:			
Notes:	Four - way intersection corners A,B,C,D

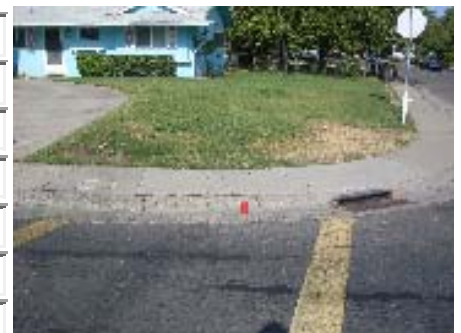
Field Date:	10/5/2010	Report Date:	10/5/2010	Barrier #:	157
Location:	Butternut Dr and Lichen Dr - Corner A (A-A)				
X Coordinate:	-121.30645				
Y Coordinate:	38.71640				
Barrier Area:	Curb Ramps				
Barrier Type:	No Curb Ramp				
Code Ref:	CBC 1127B.5.1 and ADA/ABA 402.2

As Built Meas:	1	Quantity:	EACH
Description:	No curb cut at corner (intersection)		
As Built Desc:	No curb ramp at corner		
Solution:	Demolish existing and construct curb cut		
Bar. Severity:	1 Necessary	Cost Estimate:	\$2,500.00
Implementation Priority:	2	Facility Function:	
Implementation Phase:		Implementation Date:	
Official Responsible:			
Notes:	Four - way intersection corners A,B,C,D

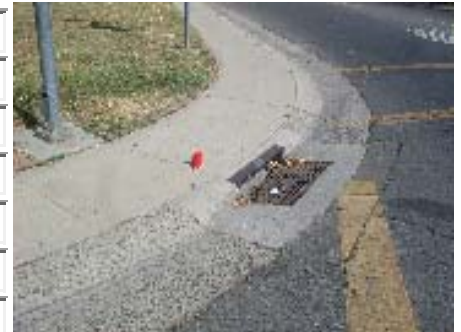
Barrier Type: No Curb Ramp

Code Ref: CBC 1127B.5.1 and ADA/ABA 402.2

As Built Meas: 1 Quantity: EACH

Description: No curb cut at corner (intersection)

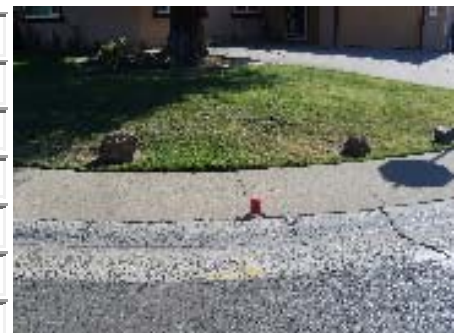
Barrier Type: No Curb Ramp

Code Ref: CBC 1127B.5.1 and ADA/ABA 402.2

As Built Meas: 1 Quantity: EACH

Description: No curb cut at corner (intersection)

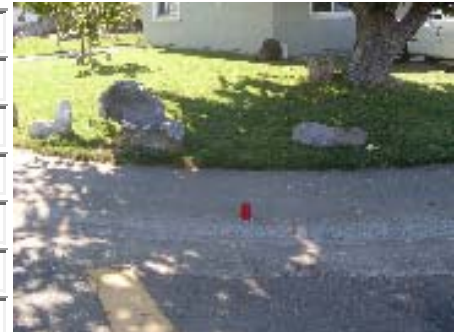
Barrier Type: No Curb Ramp

Code Ref: CBC 1127B.5.1 and ADA/ABA 402.2

As Built Meas: 1 Quantity: EACH

Description: No curb cut at corner (intersection)

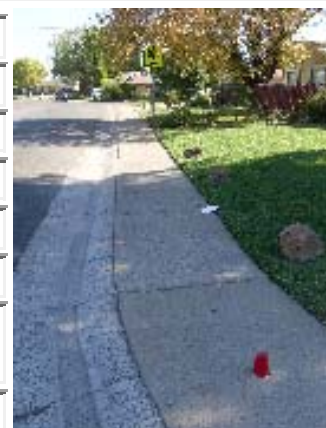
Barrier Type: Cross Slope - Existing (5.0% or more)

Code Ref: CBC 1133B.7.1.3 and ADA/ABA 403.3

As Built Meas: 163 Quantity: LF

Description: Cross slope exceeds 2.0% (5.0% or more)

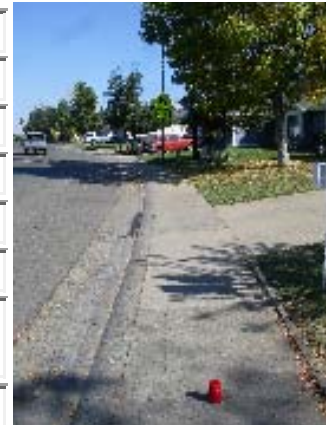
Barrier Type: Cross Slope - Existing (5.0% or more)

Code Ref: CBC 1133B.7.1.3 and ADA/ABA 403.3

As Built Meas: 300 Quantity: LF

Description: Cross slope exceeds 2.0% (5.0% or more)

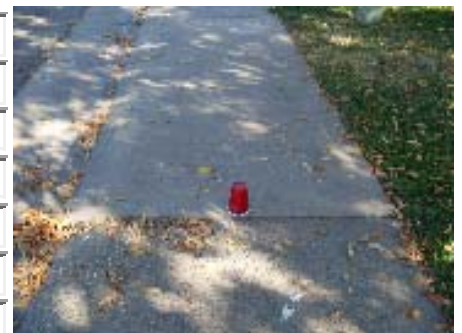
Barrier Type: Abrupt Change in Level - > 1/2"

Code Ref: CBC 1133B.7.1 and ADA/ABA 303.3

As Built Meas: 4 Quantity: LF

Description: Change in level greater than 1/2"

Solution: Grind or repair to remove trip hazard

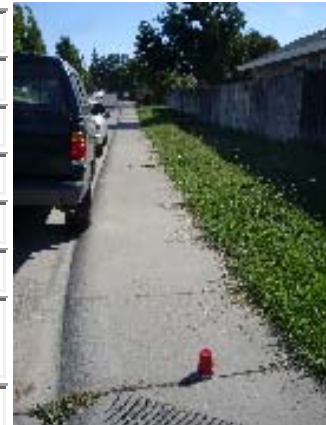
Barrier Type: Cross Slope - Existing (3.1% to 4.0%)

Code Ref: CBC 1133B.7.1.3 and ADA/ABA 403.3

As Built Meas: 175 Quantity: LF

Description: Cross slope exceeds 2.0% (3.1% to 4.0%)

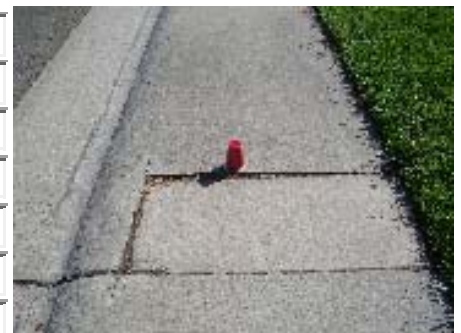
Barrier Type: Abrupt Change in Level - > 1/2"

Code Ref: CBC 1133B.7.1 and ADA/ABA 303.3

As Built Meas: 4 Quantity: LF

Description: Change in level greater than 1/2"

Solution: Grind or repair to remove trip hazard

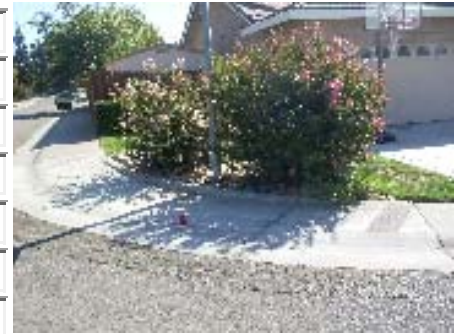
Field Date:	10/1/2010	Report Date:	10/1/2010	Barrier #:	164A
Location:	Cloverleaf Wy and Bramble Tree Wy - Corner C				
X Coordinate:	-121.30442				
Y Coordinate:	38.71793				
Barrier Area:	Curb Ramps				
Barrier Type:	12" Grooves - Existing (>5.0%)				
Code Ref:	CBC 1127B.5.6

As Built Meas:	1	Quantity:	EACH
Description:	12" grooves at top of curb ramp are not level (>5.0%)		
As Built Desc:	7.1% at 12" grooves		
Solution:	Demolish existing and construct new curb ramp		
Bar. Severity:	1 Necessary	Cost Estimate:	\$2,500.00
Implementation Priority:	4	Facility Function:	
Implementation Phase:		Implementation Date:	
Official Responsible:			
Notes:	Two - way intersection corners C,D

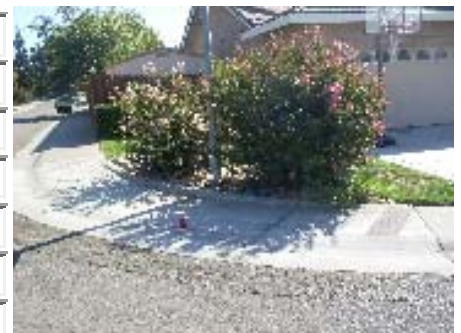
Field Date:	10/1/2010	Report Date:	10/1/2010	Barrier #:	164B
Location:	Cloverleaf Wy and Bramble Tree Wy - Corner C				
X Coordinate:	-121.30442				
Y Coordinate:	38.71793				
Barrier Area:	Curb Ramps				
Barrier Type:	Parallel Ramp Landing - New Construction				
Code Ref:	CBC 1127B.5.9 and ADA/ABA 406.4

As Built Meas:	1	Quantity:	EACH
Description:	Curb ramp pan is not level (2.0% in all directions)		
As Built Desc:	5.6% landing slope		
Solution:	Demolish existing and construct new curb ramp		
Bar. Severity:	1 Necessary	Cost Estimate:	\$0.00
Implementation Priority:	4	Facility Function:	
Implementation Phase:		Implementation Date:	
Official Responsible:			
Notes:	Two - way intersection corners C,D

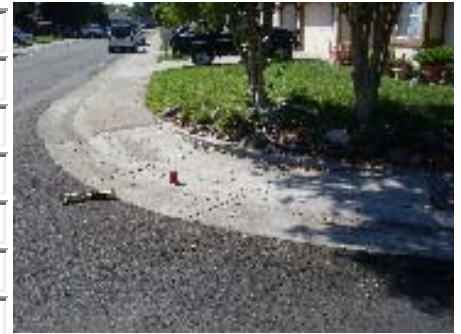
Barrier Type: Detectable Warnings - Truncated Domes

Code Ref: CBC 1127B.5.7 and ADA/ABA 705.1.3

As Built Meas: 1 Quantity: EACH

Description: No truncated domes provided at curb ramp

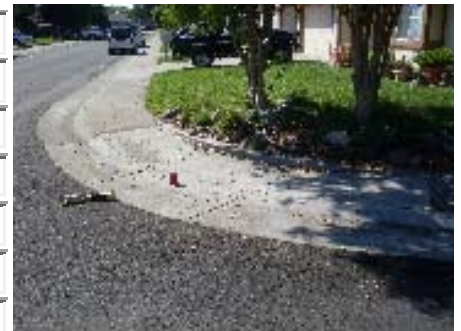
Barrier Type: Transition into Roadway - Existing (8.3% or more)

Code Ref: CBC 1127B.5.3 and ADA/ABA 406.2

As Built Meas: 16 Quantity: SF

Description: Transition from gutter into roadway slope exceeds 5.0% (8.3% or more)

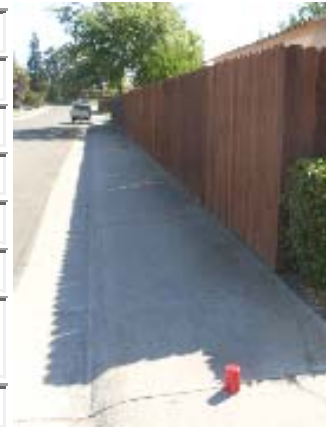
Field Date:	10/1/2010	Report Date:	10/1/2010	Barrier #:	166A
Location:	Cloverleaf Wy - South				
X Coordinate:	-121.30435				
Y Coordinate:	38.71795				
Barrier Area:	Sidewalks				
Barrier Type:	Cross Slope - Existing (3.1% to 4.0%)				
Code Ref:	CBC 1133B.7.1.3 and ADA/ABA 403.3

As Built Meas:	163	Quantity:	LF
Description:	Cross slope exceeds 2.0% (3.1% to 4.0%)		
As Built Desc:	3.6% cross slope		
Solution:	Demolish existing and construct new route		
Bar. Severity:	3 Hindrance	Cost Estimate:	\$20,375.00
Implementation Priority:	4	Facility Function:	
Implementation Phase:		Implementation Date:	
Official Responsible:			
Notes:

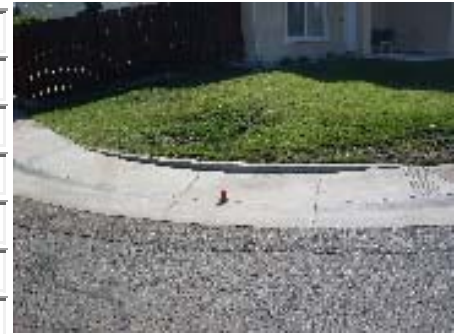
Barrier Type: 12" Grooves - New Construction

Code Ref: CBC 1127B.5.6

As Built Meas: 1 Quantity: EACH

Description: 12" grooves at top of curb ramp are not level (4.1% to 4.9%)

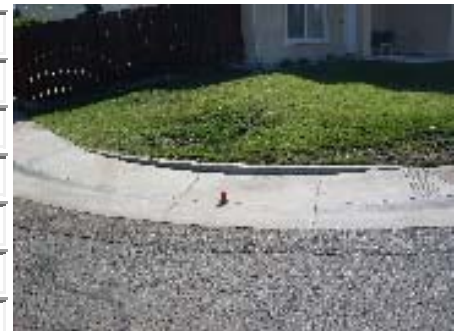
Barrier Type: Detectable Warnings - Truncated Domes (New Const)

Code Ref: CBC 1127B.5.7 and ADA/ABA 705.1.3

As Built Meas: 1 Quantity: EACH

Description: No truncated domes provided at curb ramp

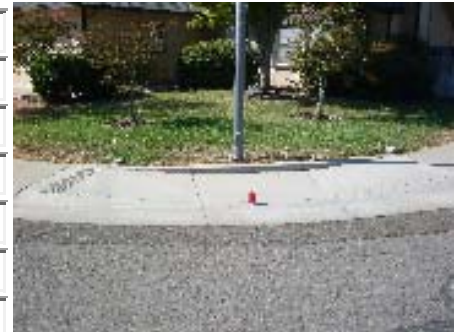
Barrier Type: Detectable Warnings - Truncated Domes (New Const)

Code Ref: CBC 1127B.5.7 and ADA/ABA 705.1.3

As Built Meas: 1 Quantity: EACH

Description: No truncated domes provided at curb ramp

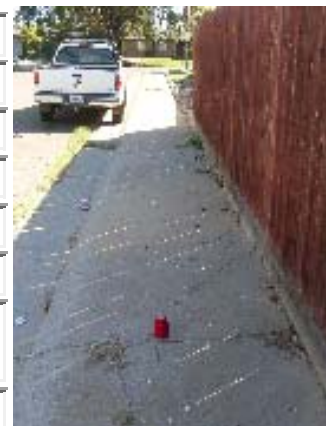
Barrier Type: Cross Slope - Existing (4.1% to 4.9%)

Code Ref: CBC 1133B.7.1.3 and ADA/ABA 403.3

As Built Meas: 82 Quantity: LF

Description: Cross slope exceeds 2.0% (4.1% to 4.9%)

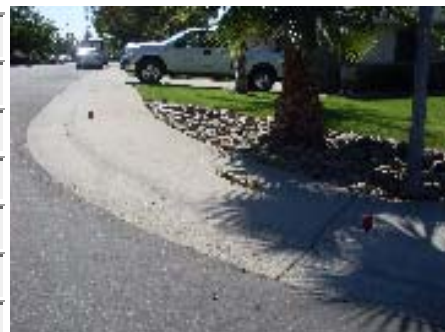
Barrier Type: Running Slope (New Construction)

Code Ref: CBC 1133B.7.3 and ADA/ABA 403.3

As Built Meas: 16 Quantity: LF

Description: Running slope exceeds 5.0% where roadway slope does not

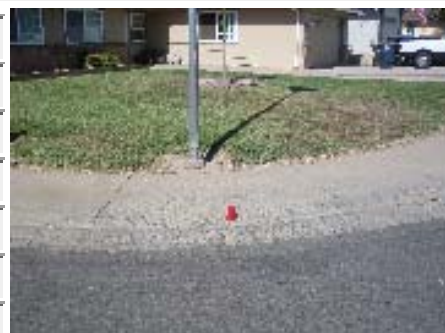
Barrier Type: Elbow in Sidewalk - Cross Slope (5.0% or more)

Code Ref: CBC 1133B.7.1.3 and ADA/ABA 403.3

As Built Meas: 8 Quantity: LF

Description: Cross slope at elbow exceeds 2.0% (5.0% or more)
