DRAFT ADA TRANSITION PLAN UPDATE
NEIGHBORHOOD AREA 1 NORTHWEST
SEPTEMBER 20, 2011

CITY OF CITRUS HEIGHTS

The Northwest Neighborhood Association

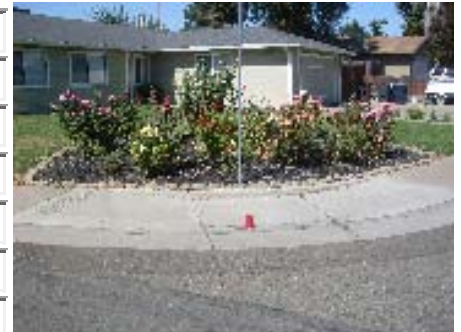
Barrier Type: Detectable Warnings - Truncated Domes (New Const)

Code Ref: CBC 1127B.5.7 and ADA/ABA 705.1.3

As Built Meas: 1 Quantity: EACH

Description: No truncated domes provided at curb ramp

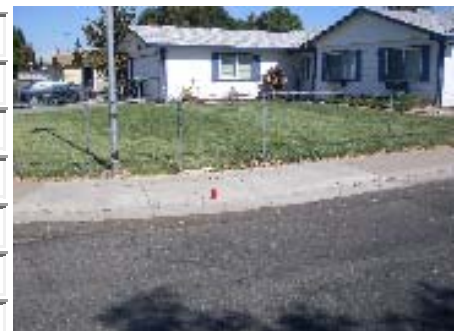
Barrier Type: Detectable Warnings - Truncated Domes (New Const)

Code Ref: CBC 1127B.5.7 and ADA/ABA 705.1.3

As Built Meas: 1 Quantity: EACH

Description: No truncated domes provided at curb ramp

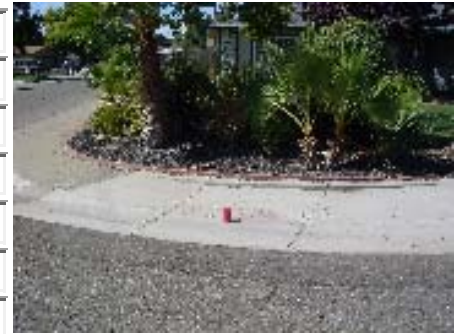
Barrier Type: 12" Grooves - New Construction

Code Ref: CBC 1127B.5.6

As Built Meas: 1 Quantity: EACH

Description: 12" grooves at top of curb ramp are not level (>5.0%)

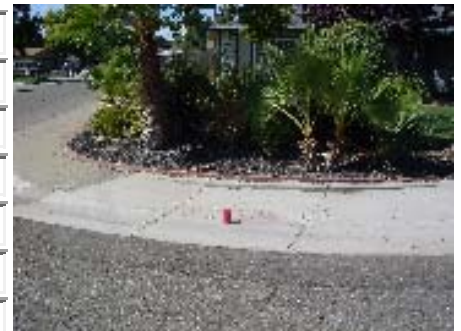
Barrier Type: Detectable Warnings - Truncated Domes (New Const)Detecta

Code Ref: CBC 1127B.5.7 and ADA/ABA 705.1.3

As Built Meas: 1 Quantity: EACH

Description: No truncated domes provided at curb ramp

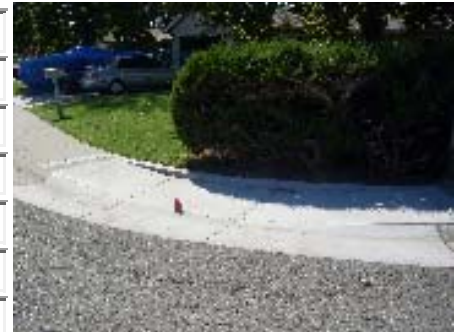
Barrier Type: Detectable Warnings - Truncated Domes (New Const)

Code Ref: CBC 1127B.5.7 and ADA/ABA 705.1.3

As Built Meas: 1 Quantity: EACH

Description: No truncated domes provided at curb ramp

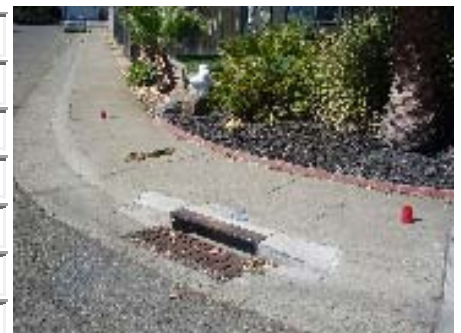
Barrier Type: Cross Slope - Existing (4.1% to 4.9%)

Code Ref: CBC 1133B.7.1.3 and ADA/ABA 403.3

As Built Meas: 16 Quantity: LF

Description: Cross slope exceeds 2.0% (4.1% to 4.9%)

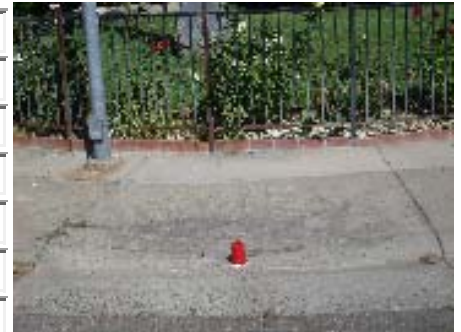
Barrier Type: Elbow in Sidewalk - Cross Slope (5.0% or more)

Code Ref: CBC 1133B.7.1.3 and ADA/ABA 403.3

As Built Meas: 6 Quantity: LF

Description: Cross slope at elbow exceeds 2.0% (5.0% or more)

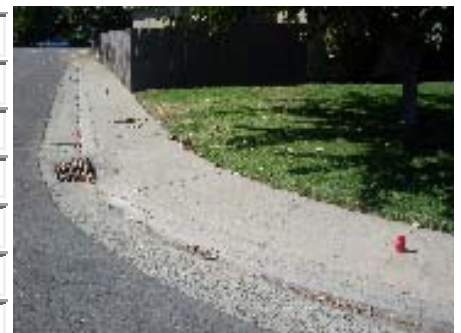
Barrier Type: Cross Slope - Existing (4.1% to 4.9%)

Code Ref: CBC 1133B.7.1.3 and ADA/ABA 403.3

As Built Meas: 38 Quantity: LF

Description: Cross slope exceeds 2.0% (4.1% to 4.9%)

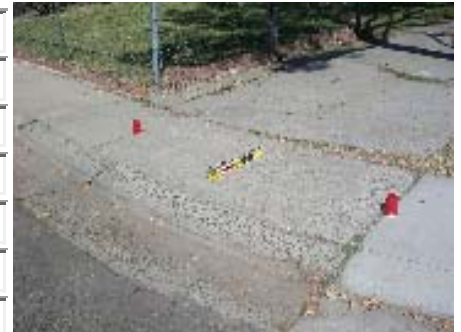
Barrier Type: Cross Slope - Existing (4.1% to 4.9%)

Code Ref: CBC 1133B.7.1.3 and ADA/ABA 403.3

As Built Meas: 8 Quantity: LF

Description: Cross slope exceeds 2.0% (4.1% to 4.9%)

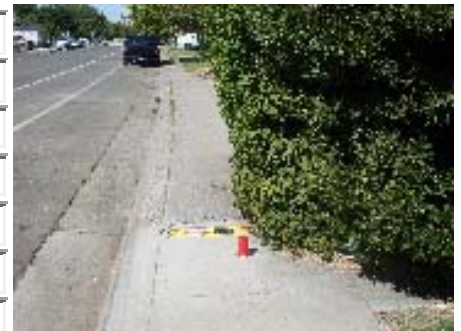
Barrier Type: Clear Width - Existing ($\leq 31"$ or less)

Code Ref: CBC 1133B.7.1

As Built Meas: 1 Quantity: LF

Description: Pedestrian route is not min. 48" wide ($\leq 31"$ or less)

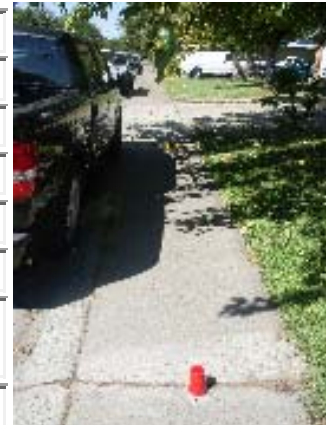
Field Date:	10/1/2010	Report Date:	10/1/2010	Barrier #:	181
Location:	Butternut Dr - North				
X Coordinate:	-121.30542				
Y Coordinate:	38.71574				
Barrier Area:	Sidewalks				
Barrier Type:	Cross Slope - Existing (5.0% or more)				
Code Ref:	CBC 1133B.7.1.3 and ADA/ABA 403.3				
As Built Meas:	34	Quantity:	LF		
Description:	Cross slope exceeds 2.0% (5.0% or more)				
As Built Desc:	7.2% cross slope				
Solution:	Demolish existing and construct new route				
Bar. Severity:	1 Necessary	Cost Estimate:	\$4,250.00	Status:	
Implementation Priority:	2	Facility Function:			
Implementation Phase:		Implementation Date:			
Official Responsible:					
Notes:

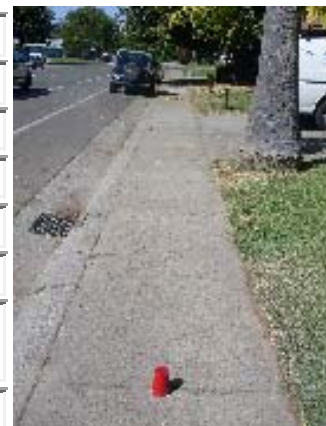
Field Date:	10/1/2010	Report Date:	10/1/2010	Barrier #:	182
Location:	Butternut Dr - North				
X Coordinate:	-121.30562				
Y Coordinate:	38.71590				
Barrier Area:	Sidewalks				
Barrier Type:	Cross Slope - Existing (5.0% or more)				
Code Ref:	CBC 1133B.7.1.3 and ADA/ABA 403.3				
As Built Meas:	217	Quantity:	LF		
Description:	Cross slope exceeds 2.0% (5.0% or more)				
As Built Desc:	5.2% cross slope				
Solution:	Demolish existing and construct new route				
Bar. Severity:	1 Necessary	Cost Estimate:	\$27,125.00	Status:	
Implementation Priority:	2	Facility Function:			
Implementation Phase:		Implementation Date:			
Official Responsible:					
Notes:

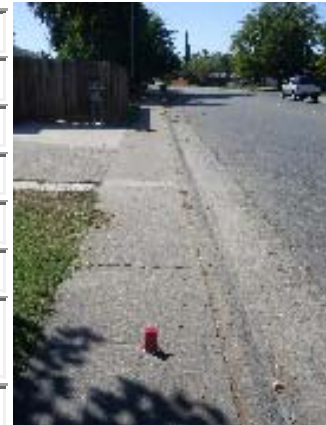
Barrier Type: Cross Slope - Existing (5.0% or more)

Code Ref: CBC 1133B.7.1.3 and ADA/ABA 403.3

As Built Meas: 1147 Quantity: LF

Description: Cross slope exceeds 2.0% (5.0% or more)

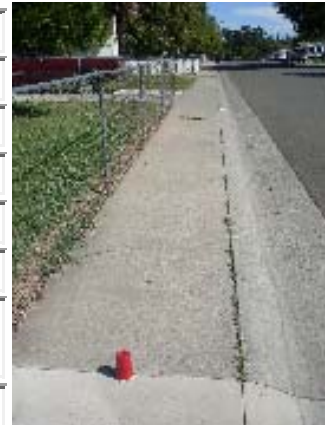
Barrier Type: Cross Slope - Existing (5.0% or more)

Code Ref: CBC 1133B.7.1.3 and ADA/ABA 403.3

As Built Meas: 147 Quantity: LF

Description: Cross slope exceeds 2.0% (5.0% or more)

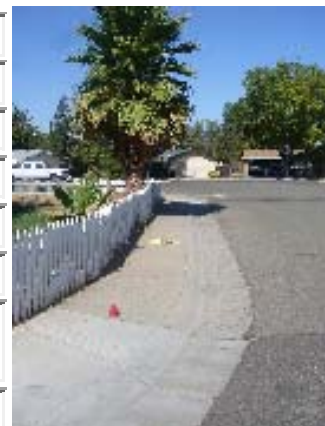
Barrier Type: Cross Slope - Existing (5.0% or more)

Code Ref: CBC 1133B.7.1.3 and ADA/ABA 403.3

As Built Meas: 200 Quantity: LF

Description: Cross slope exceeds 2.0% (5.0% or more)

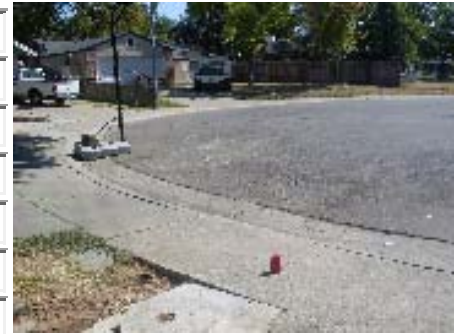
Field Date:	10/1/2010	Report Date:	10/1/2010	Barrier #:	186
Location:	Leaoak Ct - East				
X Coordinate:	-121.30740				
Y Coordinate:	38.71417				
Barrier Area:	Sidewalks				
Barrier Type:	Cross Slope - Existing (5.0% or more)				
Code Ref:	CBC 1133B.7.1.3 and ADA/ABA 403.3

As Built Meas:	210	Quantity:	LF
Description:	Cross slope exceeds 2.0% (5.0% or more)		
As Built Desc:	13.0% cross slope		
Solution:	Demolish existing and construct new route		
Bar. Severity:	1 Necessary	Cost Estimate:	\$26,250.00
Implementation Priority:	4	Facility Function:	
Implementation Phase:		Implementation Date:	
Official Responsible:			
Notes:

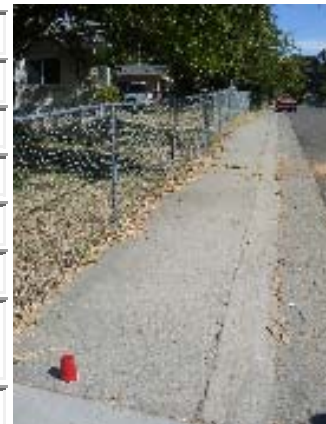
Field Date:	10/1/2010	Report Date:	10/1/2010	Barrier #:	187
Location:	Treebine Ave - North				
X Coordinate:	-121.30724				
Y Coordinate:	38.71371				
Barrier Area:	Sidewalks				
Barrier Type:	Cross Slope - Existing (5.0% or more)				
Code Ref:	CBC 1133B.7.1.3 and ADA/ABA 403.3

As Built Meas:	219	Quantity:	LF
Description:	Cross slope exceeds 2.0% (5.0% or more)		
As Built Desc:	7.1% cross slope		
Solution:	Demolish existing and construct new route		
Bar. Severity:	1 Necessary	Cost Estimate:	\$27,375.00
Implementation Priority:	4	Facility Function:	
Implementation Phase:		Implementation Date:	
Official Responsible:			
Notes:

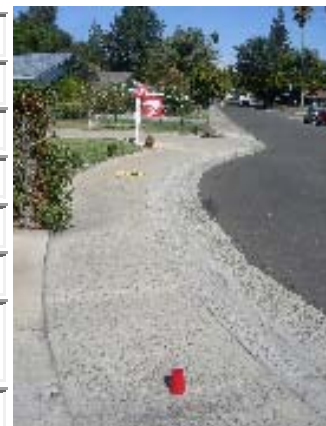
Field Date: 10/1/2010 Report Date: 10/1/2010 Barrier #: 189

Location: Basswood Wy -North

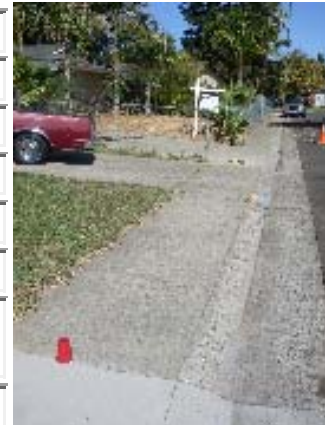
Field Date:	10/1/2010	Report Date:	10/1/2010	Barrier #:	190
Location:	Basswood Wy -North				
X Coordinate:	-121.30633				
Y Coordinate:	38.71550				
Barrier Area:	Sidewalks				
Barrier Type:	Cross Slope - Existing (5.0% or more)				
Code Ref:	CBC 1133B.7.1.3 and ADA/ABA 403.3				
As Built Meas:	177	Quantity:	LF		
Description:	Cross slope exceeds 2.0% (5.0% or more)				
As Built Desc:	6.0% cross slope				
Solution:	Demolish existing and construct new route				
Bar. Severity:	1 Necessary	Cost Estimate:	\$22,125.00	Status:	
Implementation Priority:	4	Facility Function:			
Implementation Phase:		Implementation Date:			
Official Responsible:					
Notes:

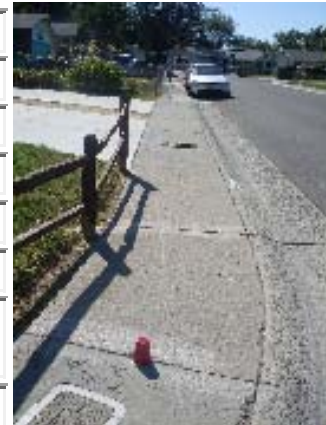
Field Date:	10/1/2010	Report Date:	10/1/2010	Barrier #:	192
Location:	Basswood Wy -South				
X Coordinate:	-121.30640				
Y Coordinate:	38.71532				
Barrier Area:	Sidewalks				
Barrier Type:	Cross Slope - Existing (5.0% or more)				
Code Ref:	CBC 1133B.7.1.3 and ADA/ABA 403.3

As Built Meas:	195	Quantity:	LF
Description:	Cross slope exceeds 2.0% (5.0% or more)		
As Built Desc:	5.2% cross slope		
Solution:	Demolish existing and construct new route		
Bar. Severity:	1 Necessary	Cost Estimate:	\$24,375.00
Implementation Priority:	4	Facility Function:	
Implementation Phase:		Implementation Date:	
Official Responsible:			
Notes:

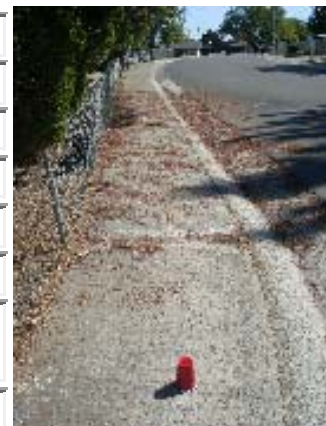
Field Date:	10/1/2010	Report Date:	10/1/2010	Barrier #:	193
Location:	Basswood Wy -East				
X Coordinate:	-121.30689				
Y Coordinate:	38.71495				
Barrier Area:	Sidewalks				
Barrier Type:	Cross Slope - Existing (5.0% or more)				
Code Ref:	CBC 1133B.7.1.3 and ADA/ABA 403.3

As Built Meas:	483	Quantity:	LF
Description:	Cross slope exceeds 2.0% (5.0% or more)		
As Built Desc:	6.2% cross slope		
Solution:	Demolish existing and construct new route		
Bar. Severity:	1 Necessary	Cost Estimate:	\$60,375.00
Implementation Priority:	4	Facility Function:	
Implementation Phase:		Implementation Date:	
Official Responsible:			
Notes:

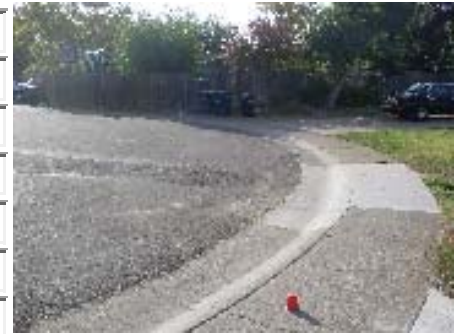
Field Date:	10/4/2010	Report Date:	10/4/2010	Barrier #:	203
Location:	Mimosa Ct - South				
X Coordinate:	-121.30623				
Y Coordinate:	38.71252				
Barrier Area:	Sidewalks				
Barrier Type:	Cross Slope - Existing (5.0% or more)				
Code Ref:	CBC 1133B.7.1.3 and ADA/ABA 403.3

As Built Meas:	189	Quantity:	LF
Description:	Cross slope exceeds 2.0% (5.0% or more)		
As Built Desc:	6.6% cross slope		
Solution:	Demolish existing and construct new route		
Bar. Severity:	1 Necessary	Cost Estimate:	\$23,625.00
Implementation Priority:	4	Facility Function:	
Implementation Phase:		Implementation Date:	
Official Responsible:			
Notes:

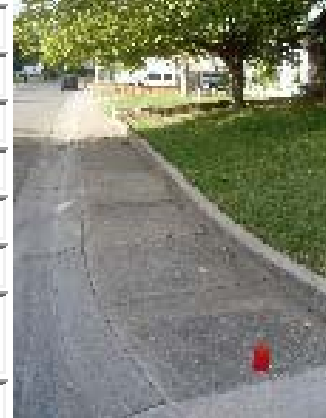
Field Date:	10/4/2010	Report Date:	10/4/2010	Barrier #:	204A
Location:	Buttonwood Way - West				
X Coordinate:	-121.30618				
Y Coordinate:	38.71245				
Barrier Area:	Sidewalks				
Barrier Type:	Cross Slope - Existing (5.0% or more)				
Code Ref:	CBC 1133B.7.1.3 and ADA/ABA 403.3

As Built Meas:	341	Quantity:	LF
Description:	Cross slope exceeds 2.0% (5.0% or more)		
As Built Desc:	6.0% cross slope		
Solution:	Demolish existing and construct new route		
Bar. Severity:	1 Necessary	Cost Estimate:	\$42,625.00
Implementation Priority:	4	Facility Function:	
Implementation Phase:		Implementation Date:	
Official Responsible:			
Notes:

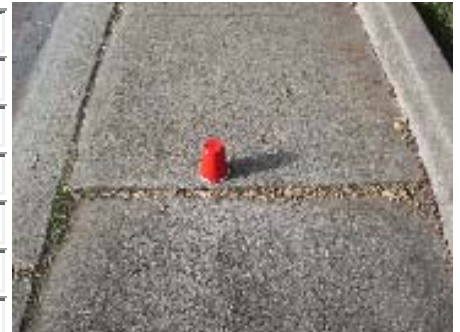
Field Date:	10/4/2010	Report Date:	10/4/2010	Barrier #:	204B
Location:	Buttonwood Way - West				
X Coordinate:	-121.30626				
Y Coordinate:	38.71237				
Barrier Area:	Sidewalks				
Barrier Type:	Abrupt Change in Level - > 1/2"				
Code Ref:	CBC 1133B.7.1 and ADA/ABA 303.3

As Built Meas:	4	Quantity:	LF
Description:	Change in level greater than 1/2"		
As Built Desc:	1" lip in sidewalk surface		
Solution:	Grind or repair to remove trip hazard		
Bar. Severity:	1 Necessary	Cost Estimate:	\$1,000.00
Implementation Priority:	4	Facility Function:	
Implementation Phase:		Implementation Date:	
Official Responsible:			
Notes:

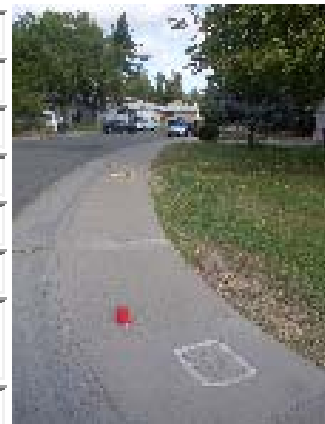
Field Date:	10/4/2010	Report Date:	10/4/2010	Barrier #:	205A
Location:	Treelark Wy - East				
X Coordinate:	-121.30701				
Y Coordinate:	38.71171				
Barrier Area:	Sidewalks				
Barrier Type:	Cross Slope - Existing (5.0% or more)				
Code Ref:	CBC 1133B.7.1.3 and ADA/ABA 403.3

As Built Meas:	494	Quantity:	LF
Description:	Cross slope exceeds 2.0% (5.0% or more)		
As Built Desc:	5.8% cross slope		
Solution:	Demolish existing and construct new route		
Bar. Severity:	1 Necessary	Cost Estimate:	\$61,750.00
Implementation Priority:	4	Facility Function:	
Implementation Phase:		Implementation Date:	
Official Responsible:			
Notes:

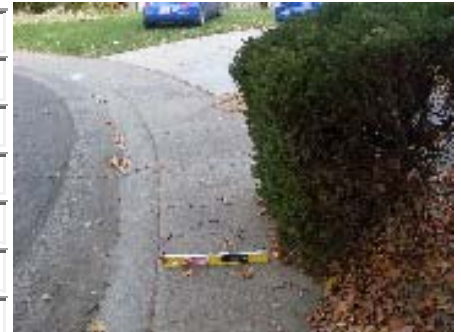
Field Date:	10/4/2010	Report Date:	10/4/2010	Barrier #:	205B
Location:	Treelark Wy - East				
X Coordinate:	-121.30740				
Y Coordinate:	38.71292				
Barrier Area:	Sidewalks				
Barrier Type:	Clear Width - Existing ($\leq 31"$ or less)				
Code Ref:	CBC 1133B.7.1

As Built Meas:	1	Quantity:	LF
Description:	Pedestrian route is not min. 48" wide ($\leq 31"$ or less)		
As Built Desc:	24" clear width due to foliage		
Solution:	Trim foliage to provide min. 48" clear width		
Bar. Severity:	1 Necessary	Cost Estimate:	\$125.00
Implementation Priority:	4	Facility Function:	
Implementation Phase:		Implementation Date:	
Official Responsible:			
Notes:

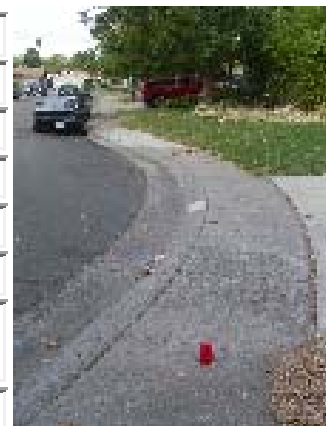
Field Date:	10/4/2010	Report Date:	10/4/2010	Barrier #:	206
Location:	Treelark Wy - North				
X Coordinate:	-121.30743				
Y Coordinate:	38.71297				
Barrier Area:	Sidewalks				
Barrier Type:	Cross Slope - Existing (5.0% or more)				
Code Ref:	CBC 1133B.7.1.3 and ADA/ABA 403.3

As Built Meas:	246	Quantity:	LF
Description:	Cross slope exceeds 2.0% (5.0% or more)		
As Built Desc:	5.0% cross slope		
Solution:	Demolish existing and construct new route		
Bar. Severity:	1 Necessary	Cost Estimate:	\$30,750.00
Implementation Priority:	4	Facility Function:	
Implementation Phase:		Implementation Date:	
Official Responsible:			
Notes:

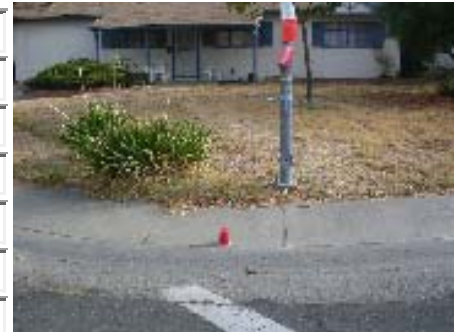
Barrier Type: No Curb Ramp

Description: No curb cut at corner (intersection)

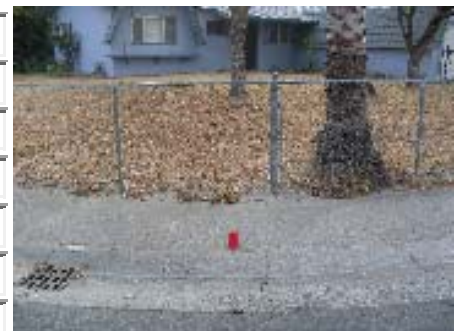
Barrier Type: No Curb Ramp

Description: No curb cut at corner (intersection)

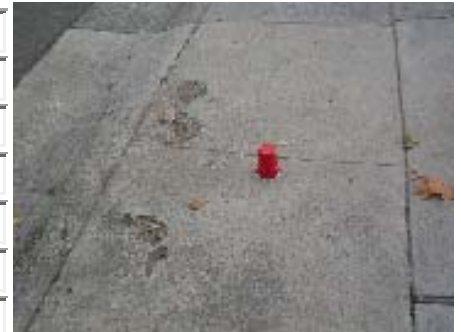
Field Date:	10/4/2010	Report Date:	10/4/2010	Barrier #:	214B
Location:	Buttonwood Way - East				
X Coordinate:	-121.30586				
Y Coordinate:	38.71264				
Barrier Area:	Sidewalks				
Barrier Type:	Surface Condition - Damaged				
Code Ref:	CBC 1133B.7.1 and ADA/ABA 302.1

As Built Meas:	8	Quantity:	LF
Description:	Surface is not firm and stable (cracked, broken or loose soil, etc.)		
As Built Desc:	Broken concrete		
Solution:	Repair surface to make firm and stable		
Bar. Severity:	1 Necessary	Cost Estimate:	\$1,000.00
Implementation Priority:	4	Facility Function:	
Implementation Phase:		Implementation Date:	
Official Responsible:			
Notes:

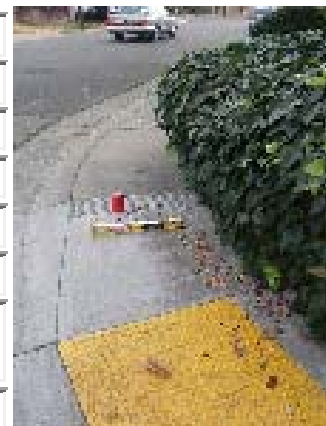
Field Date:	10/4/2010	Report Date:	10/4/2010	Barrier #:	215A
Location:	Oakmyrtle Wy - South				
X Coordinate:	-121.30560				
Y Coordinate:	38.71299				
Barrier Area:	Sidewalks				
Barrier Type:	Clear Width - Existing (32" to 35")				
Code Ref:	CBC 1133B.7.1

As Built Meas:	1	Quantity:	LF
Description:	Pedestrian route is not min. 48" wide (32" to 35")		
As Built Desc:	32" clear width due to foliage		
Solution:	Trim foliage to provide min. 48" clear width		
Bar. Severity:	1 Necessary	Cost Estimate:	\$125.00
Implementation Priority:	4	Facility Function:	
Implementation Phase:		Implementation Date:	
Official Responsible:			
Notes:

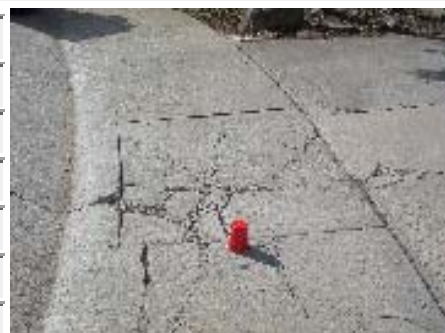
Barrier Type: Surface Condition - Damaged

Description: Surface is not firm and stable (cracked, broken or loose soil, etc.)

As Built Desc: Cracked concrete

Solution: Repair surface to make firm and stable

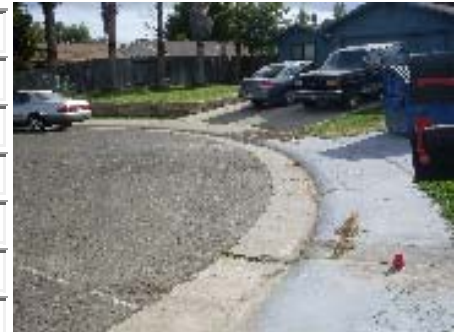
Field Date:	10/4/2010	Report Date:	10/4/2010	Barrier #:	218
Location:	Pronghorn Ct - East				
X Coordinate:	-121.31051				
Y Coordinate:	38.72057				
Barrier Area:	Sidewalks				
Barrier Type:	Cross Slope - Existing (5.0% or more)				
Code Ref:	CBC 1133B.7.1.3 and ADA/ABA 403.3

As Built Meas:	197	Quantity:	LF
Description:	Cross slope exceeds 2.0% (5.0% or more)		
As Built Desc:	5.2% cross slope		
Solution:	Demolish existing and construct new route		
Bar. Severity:	1 Necessary	Cost Estimate:	\$24,625.00
Implementation Priority:	4	Facility Function:	
Implementation Phase:		Implementation Date:	
Official Responsible:

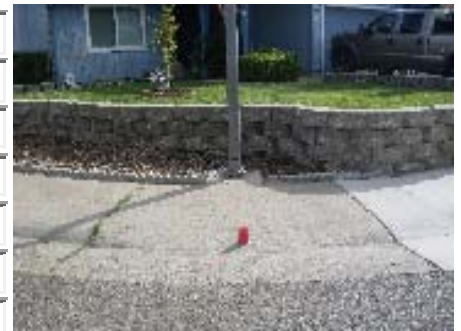
Field Date:	10/4/2010	Report Date:	10/4/2010	Barrier #:	219
Location:	Pronghorn Ct and Ibex Woods Ct - Corner B				
X Coordinate:	-121.31003				
Y Coordinate:	38.72093				
Barrier Area:	Curb Ramps				
Barrier Type:	No Curb Ramp - Depressed Existing Curb				
Code Ref:	CBC 1127B.5.1 and ADA/ABA 402.2

As Built Meas:	1	Quantity:	EACH
Description:	No compliant curb cut at corner (intersection)		
As Built Desc:	12.4% running slope at depressed area		
Solution:	Demolish existing and construct curb cut		
Bar. Severity:	1 Necessary	Cost Estimate:	\$2,500.00
Implementation Priority:	4	Facility Function:	
Implementation Phase:		Implementation Date:	
Official Responsible:

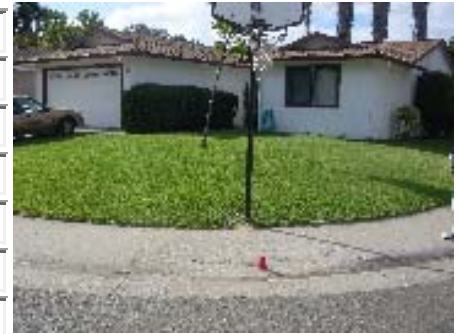
Field Date:	10/4/2010	Report Date:	10/4/2010	Barrier #:	220
Location:	Pronghorn Ct and Ibex Woods Ct - Corner C				
X Coordinate:	-121.31014				
Y Coordinate:	38.72091				
Barrier Area:	Curb Ramps				
Barrier Type:	No Curb Ramp - Depressed Existing Curb				
Code Ref:	CBC 1127B.5.1 and ADA/ABA 402.2

As Built Meas:	1	Quantity:	EACH
Description:	No compliant curb cut at corner (intersection)		
As Built Desc:	10.8% running slope at depressed area		
Solution:	Demolish existing and construct curb cut		
Bar. Severity:	1 Necessary	Cost Estimate:	\$2,500.00
Implementation Priority:	4	Facility Function:	
Implementation Phase:		Implementation Date:	
Official Responsible:			
Notes:	Two - way intersection corners B,C

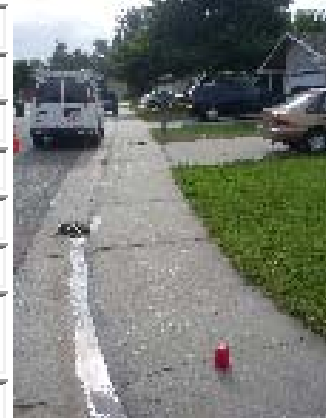
Field Date:	10/4/2010	Report Date:	10/4/2010	Barrier #:	221A
Location:	Ibex Woods Ct - South				
X Coordinate:	-121.31010				
Y Coordinate:	38.72091				
Barrier Area:	Sidewalks				
Barrier Type:	Cross Slope - Existing (5.0% or more)				
Code Ref:	CBC 1133B.7.1.3 and ADA/ABA 403.3

As Built Meas:	277	Quantity:	LF
Description:	Cross slope exceeds 2.0% (5.0% or more)		
As Built Desc:	6.3% cross slope		
Solution:	Demolish existing and construct new route		
Bar. Severity:	1 Necessary	Cost Estimate:	\$34,625.00
Implementation Priority:	4	Facility Function:	
Implementation Phase:		Implementation Date:	
Official Responsible:			
Notes:

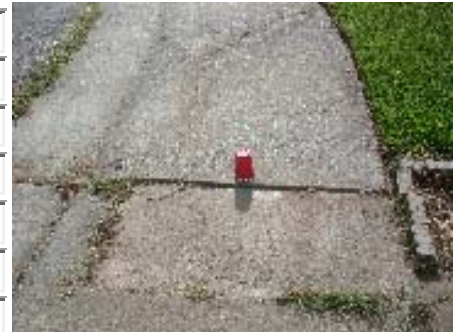
Barrier Type: Abrupt Change in Level - > 1/2"

Description: Change in level greater than 1/2"

Solution: Grind or repair sidewalk to remove trip hazard

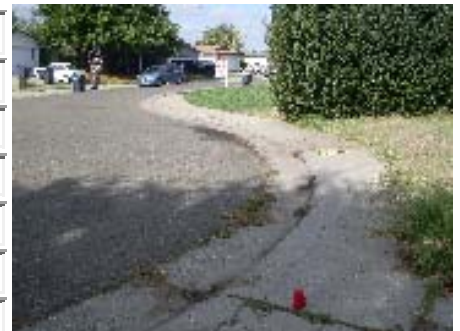
Barrier Type: Cross Slope - Existing (5.0% or more)

Code Ref: CBC 1133B.7.1.3 and ADA/ABA 403.3

As Built Meas: 294 Quantity: LF

Description: Cross slope exceeds 2.0% (5.0% or more)

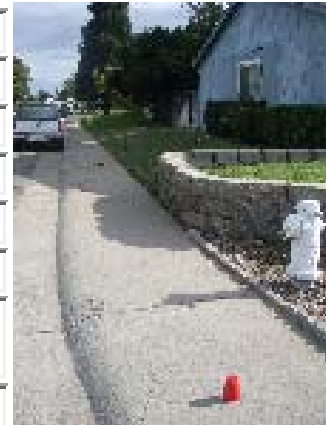
Barrier Type: Cross Slope - Existing (4.1% to 4.9%)

Code Ref: CBC 1133B.7.1.3 and ADA/ABA 403.3

As Built Meas: 187 Quantity: LF

Description: Cross slope exceeds 2.0% (4.1% to 4.9%)

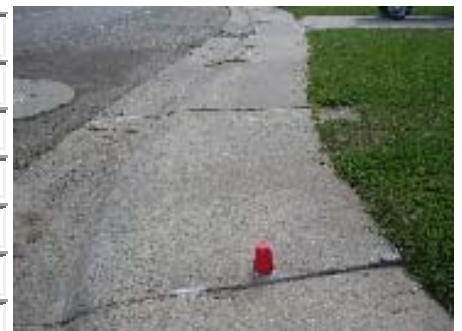
Barrier Type: Cross Slope - Existing (5.0% or more)

Code Ref: CBC 1133B.7.1.3 and ADA/ABA 403.3

As Built Meas: 1050 Quantity: LF

Description: Cross slope exceeds 2.0% (5.0% or more)

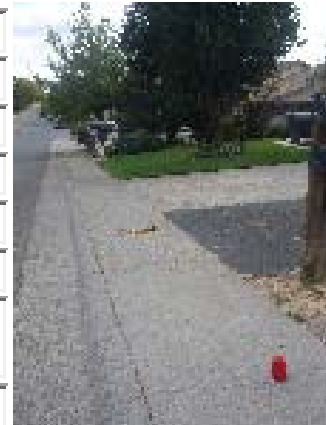
Barrier Type: Cross Slope - Existing (5.0% or more)

Code Ref: CBC 1133B.7.1.3 and ADA/ABA 403.3

As Built Meas: 192 Quantity: LF

Description: Cross slope exceeds 2.0% (5.0% or more)

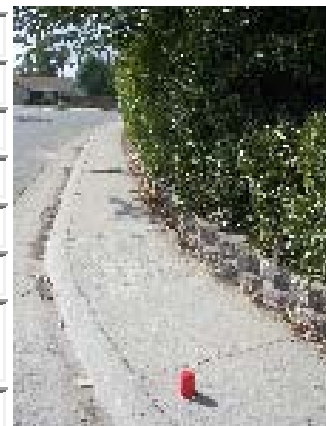
Barrier Type: Cross Slope - Existing (5.0% or more)

Code Ref: CBC 1133B.7.1.3 and ADA/ABA 403.3

As Built Meas: 475 Quantity: LF

Description: Cross slope exceeds 2.0% (5.0% or more)

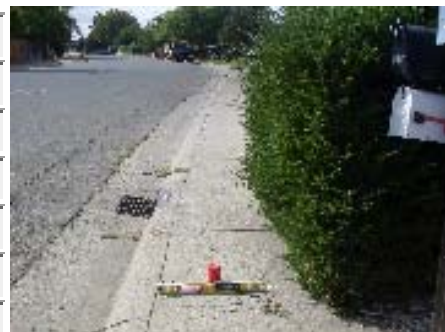
Barrier Type: Clear Width - Existing (32" to 35")

Code Ref: CBC 1133B.7.1

As Built Meas: 1 Quantity: LF

Description: Pedestrian route is not min. 48" wide (32" to 35")

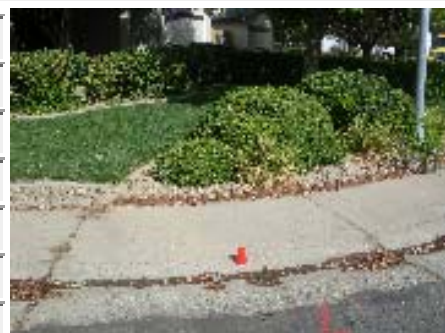
Barrier Type: No Curb Ramp - Depressed Existing Curb

Code Ref: CBC 1127B.5.1 and ADA/ABA 402.2

As Built Meas: 1 Quantity: EACH

Description: No compliant curb cut at corner (intersection)

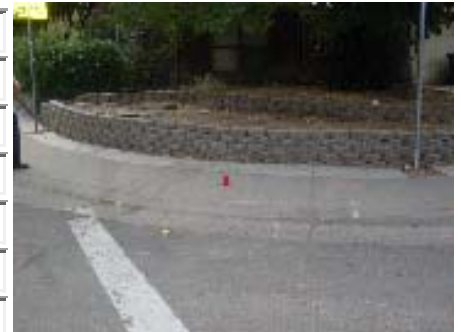
Field Date:	10/4/2010	Report Date:	10/4/2010	Barrier #:	228
Location:	Lichen Dr and Villaview Dr - Corner D				
X Coordinate:	-121.30547				
Y Coordinate:	38.71980				
Barrier Area:	Curb Ramps				
Barrier Type:	No Curb Ramp - Depressed Existing Curb				
Code Ref:	CBC 1127B.5.1 and ADA/ABA 402.2

As Built Meas:	1	Quantity:	EACH
Description:	No compliant curb cut at corner (intersection)		
As Built Desc:	15.0% running slope at depressed area		
Solution:	Demolish existing and construct curb cut		
Bar. Severity:	1 Necessary	Cost Estimate:	\$2,500.00
Implementation Priority:	2	Facility Function:	
Implementation Phase:		Implementation Date:	
Official Responsible:			
Notes:	Two - way intersection corners A,D

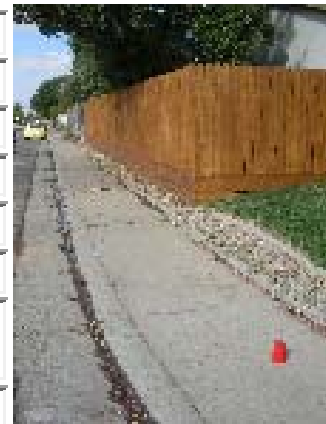
Field Date:	10/4/2010	Report Date:	10/4/2010	Barrier #:	229
Location:	Villaview Dr - North				
X Coordinate:	-121.30556				
Y Coordinate:	38.72000				
Barrier Area:	Sidewalks				
Barrier Type:	Cross Slope - Existing (4.1% to 4.9%)				
Code Ref:	CBC 1133B.7.1.3 and ADA/ABA 403.3

As Built Meas:	177	Quantity:	LF
Description:	Cross slope exceeds 2.0% (4.1% to 4.9%)		
As Built Desc:	4.3% cross slope		
Solution:	Demolish existing and construct new route		
Bar. Severity:	2 Recommended	Cost Estimate:	\$22,125.00
Implementation Priority:	4	Facility Function:	
Implementation Phase:		Implementation Date:	
Official Responsible:			
Notes:

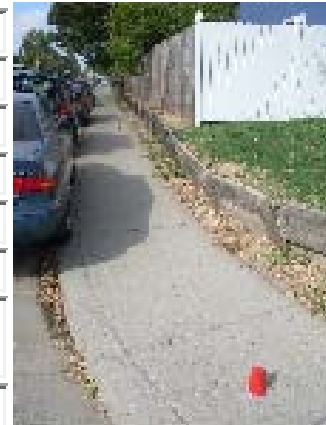
Barrier Type: Cross Slope - Existing (4.1% to 4.9%)

Code Ref: CBC 1133B.7.1.3 and ADA/ABA 403.3

As Built Meas: 563 Quantity: LF

Description: Cross slope exceeds 2.0% (4.1% to 4.9%)

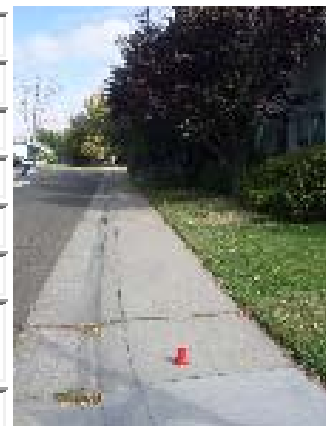
Barrier Type: Cross Slope - Existing (4.1% to 4.9%)

Code Ref: CBC 1133B.7.1.3 and ADA/ABA 403.3

As Built Meas: 188 Quantity: LF

Description: Cross slope exceeds 2.0% (4.1% to 4.9%)

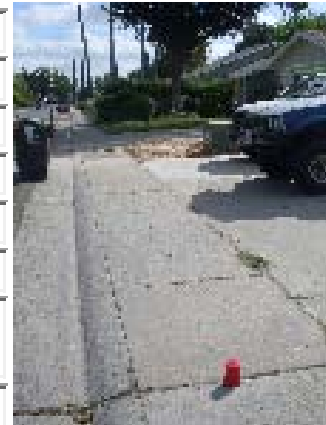
Barrier Type: Cross Slope - Existing (4.1% to 4.9%)

Code Ref: CBC 1133B.7.1.3 and ADA/ABA 403.3

As Built Meas: 550 Quantity: LF

Description: Cross slope exceeds 2.0% (4.1% to 4.9%)

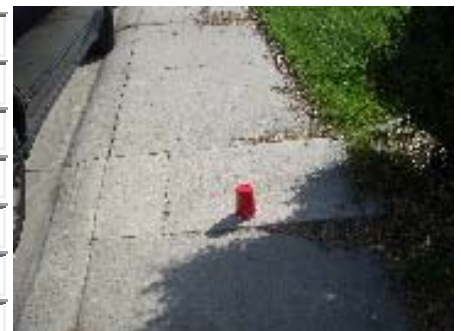
Barrier Type: Abrupt Change in Level - > 1/2"

Code Ref: CBC 1133B.7.1 and ADA/ABA 303.3

As Built Meas: 4 Quantity: LF

Description: Change in level greater than 1/2"

Solution: Grind or repair to remove trip hazard

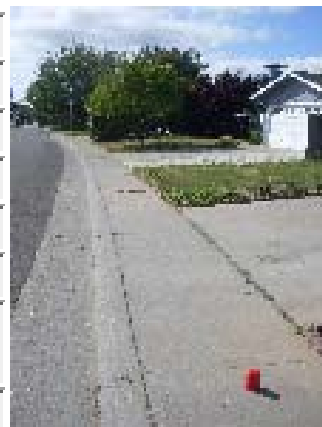
Barrier Type: Cross Slope - Existing (4.1% to 4.9%)

Code Ref: CBC 1133B.7.1.3 and ADA/ABA 403.3

As Built Meas: 188 Quantity: LF

Description: Cross slope exceeds 2.0% (4.1% to 4.9%)

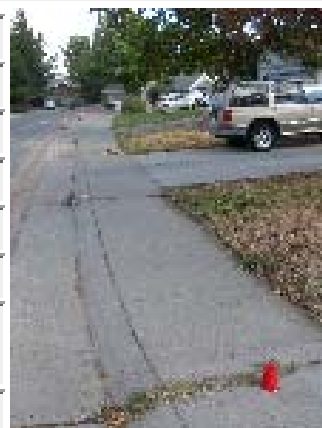
Barrier Type: Cross Slope - Existing (4.1% to 4.9%)

Code Ref: CBC 1133B.7.1.3 and ADA/ABA 403.3

As Built Meas: 252 Quantity: LF

Description: Cross slope exceeds 2.0% (4.1% to 4.9%)

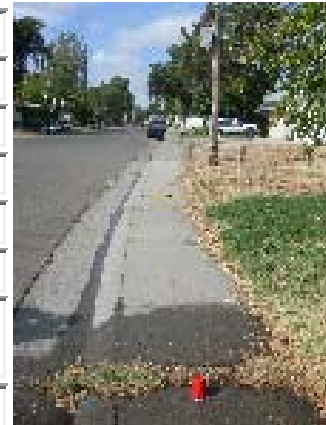
Barrier Type: Cross Slope - Existing (5.0% or more)

Code Ref: CBC 1133B.7.1.3 and ADA/ABA 403.3

As Built Meas: 483 Quantity: LF

Description: Cross slope exceeds 2.0% (5.0% or more)

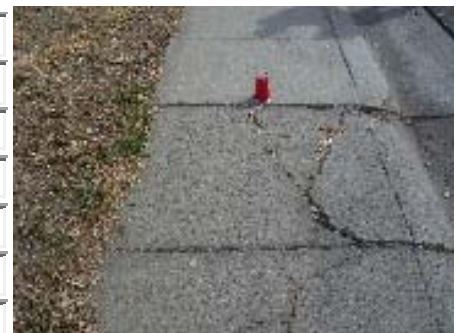
Barrier Type: Surface Condition - Damaged

Code Ref: CBC 1133B.7.1 and ADA/ABA 302.1

As Built Meas: 20 Quantity: LF

Description: Surface is not firm and stable (cracked, broken or loose soil, etc.)

As Built Desc: Cracked concrete

Solution: Repair surface to make firm and stable

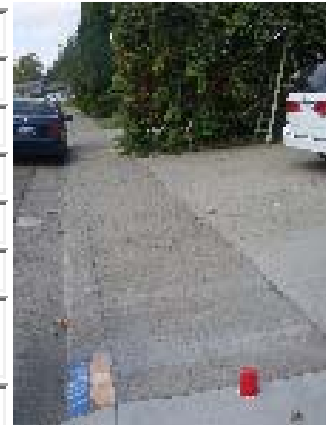
Barrier Type: Cross Slope - Existing (5.0% or more)

Code Ref: CBC 1133B.7.1.3 and ADA/ABA 403.3

As Built Meas: 350 Quantity: LF

Description: Cross slope exceeds 2.0% (5.0% or more)

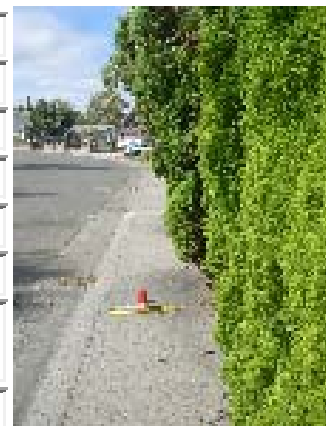
Barrier Type: Clear Width - Existing ($\leq 31"$ or less)

Code Ref: CBC 1133B.7.1

As Built Meas: 1 Quantity: LF

Description: Pedestrian route is not min. 48" wide ($\leq 31"$ or less)

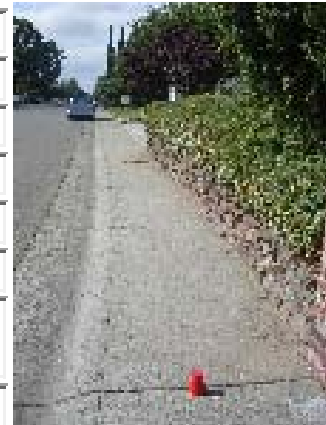
Barrier Type: Cross Slope - Existing (5.0% or more)

Code Ref: CBC 1133B.7.1.3 and ADA/ABA 403.3

As Built Meas: 600 Quantity: LF

Description: Cross slope exceeds 2.0% (5.0% or more)

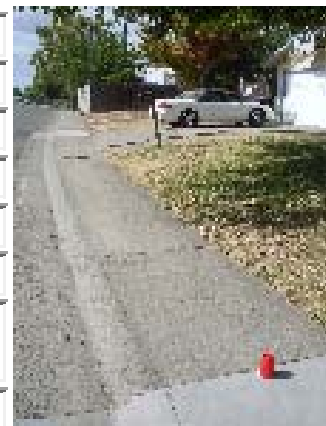
Barrier Type: Cross Slope - Existing (5.0% or more)

Code Ref: CBC 1133B.7.1.3 and ADA/ABA 403.3

As Built Meas: 181 Quantity: LF

Description: Cross slope exceeds 2.0% (5.0% or more)

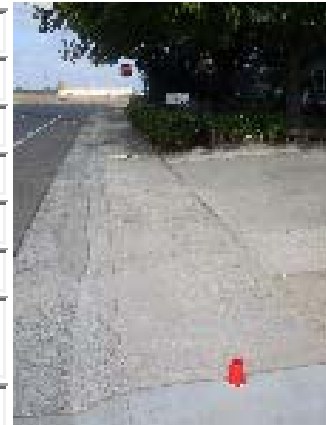
Field Date:	10/4/2010	Report Date:	10/4/2010	Barrier #:	241
Location:	Butternut Dr - North				
X Coordinate:	-121.31342				
Y Coordinate:	38.71812				
Barrier Area:	Sidewalks				
Barrier Type:	Cross Slope - Existing (4.1% to 4.9%)				
Code Ref:	CBC 1133B.7.1.3 and ADA/ABA 403.3

As Built Meas:	100	Quantity:	LF
Description:	Cross slope exceeds 2.0% (4.1% to 4.9%)		
As Built Desc:	4.2% cross slope		
Solution:	Demolish existing and construct new route		
Bar. Severity:	2 Recommended	Cost Estimate:	\$12,500.00
Implementation Priority:	2	Facility Function:	
Implementation Phase:		Implementation Date:	
Official Responsible:			
Notes:

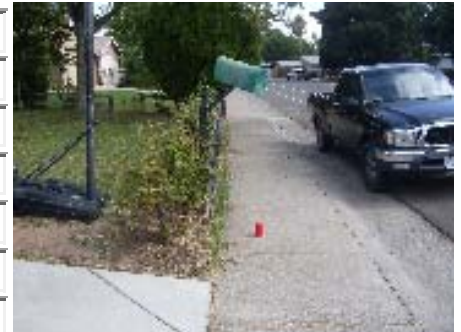
Field Date:	10/4/2010	Report Date:	10/4/2010	Barrier #:	243
Location:	Butternut Dr - North				
X Coordinate:	-121.31168				
Y Coordinate:	38.71720				
Barrier Area:	Sidewalks				
Barrier Type:	Protruding Hazard				
Code Ref:	CBC 1133B.8.6.1 and ADA/ABA 307.2

As Built Meas:	1	Quantity:	JOB
Description:	Protruding object in route of travel between 27" and 80" high		
As Built Desc:	48" protruding hazard at mailbox		
Solution:	Remove object or provide detectable warning		
Bar. Severity:	1 Necessary	Cost Estimate:	\$1,400.00
Implementation Priority:	2	Facility Function:	
Implementation Phase:		Implementation Date:	
Official Responsible:			
Notes:

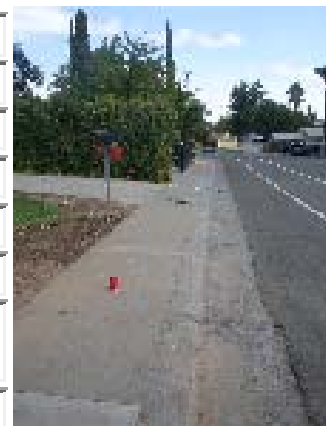
Field Date:	10/4/2010	Report Date:	10/4/2010	Barrier #:	244
Location:	Butternut Dr - North				
X Coordinate:	-121.31152				
Y Coordinate:	38.71718				
Barrier Area:	Sidewalks				
Barrier Type:	Cross Slope - Existing (5.0% or more)				
Code Ref:	CBC 1133B.7.1.3 and ADA/ABA 403.3

As Built Meas:	586	Quantity:	LF
Description:	Cross slope exceeds 2.0% (5.0% or more)		
As Built Desc:	5.7% cross slope		
Solution:	Demolish existing and construct new route		
Bar. Severity:	1 Necessary	Cost Estimate:	\$73,250.00
Implementation Priority:	2	Facility Function:	
Implementation Phase:		Implementation Date:	
Official Responsible:			
Notes:

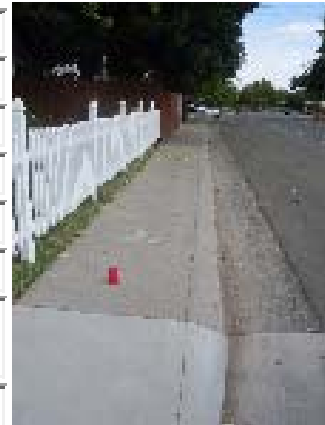
Barrier Type: Cross Slope - Existing (5.0% or more)

Code Ref: CBC 1133B.7.1.3 and ADA/ABA 403.3

As Built Meas: 205 Quantity: LF

Description: Cross slope exceeds 2.0% (5.0% or more)

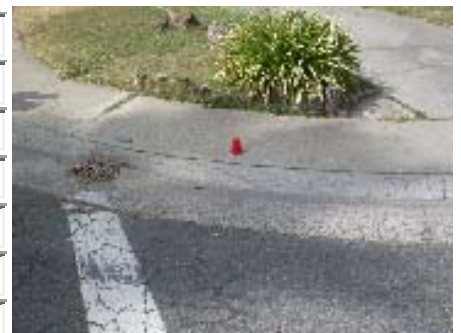
Barrier Type: No Curb Ramp

Code Ref: CBC 1127B.5.1 and ADA/ABA 402.2

As Built Meas: 1 Quantity: EACH

Description: No curb cut at corner (intersection)

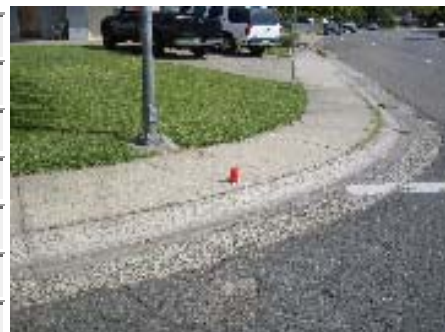
Barrier Type: No Curb Ramp

Code Ref: CBC 1127B.5.1 and ADA/ABA 402.2

As Built Meas: 1 Quantity: EACH

Description: No curb cut at corner (intersection)

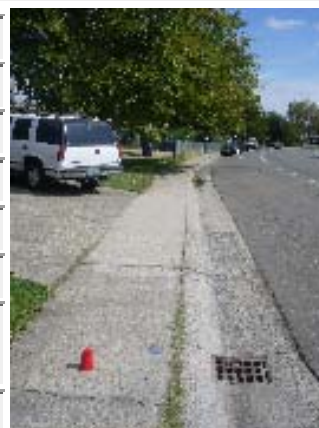
Barrier Type: Cross Slope - Existing (5.0% or more)

Code Ref: CBC 1133B.7.1.3 and ADA/ABA 403.3

As Built Meas: 660 Quantity: LF

Description: Cross slope exceeds 2.0% (5.0% or more)

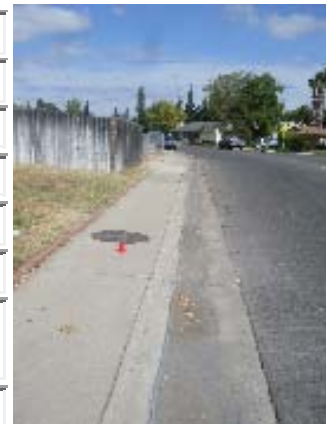
Field Date:	10/4/2010	Report Date:	10/4/2010	Barrier #:	249
Location:	Lichen Dr - West				
X Coordinate:	-121.30623				
Y Coordinate:	38.71654				
Barrier Area:	Sidewalks				
Barrier Type:	Cross Slope - Existing (5.0% or more)				
Code Ref:	CBC 1133B.7.1.3 and ADA/ABA 403.3

As Built Meas:	117	Quantity:	LF
Description:	Cross slope exceeds 2.0% (5.0% or more)		
As Built Desc:	5.2% cross slope		
Solution:	Demolish existing and construct new route		
Bar. Severity:	1 Necessary	Cost Estimate:	\$14,625.00
Implementation Priority:	2	Facility Function:	
Implementation Phase:		Implementation Date:	
Official Responsible:			
Notes:

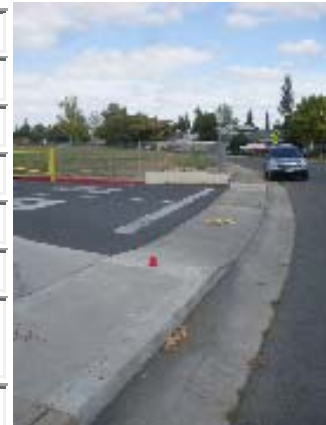
Barrier Type: Driveway - New Construction

Code Ref: CBC 1133B.7.1.3 and ADA/ABA 403.3

As Built Meas: 43 Quantity: LF

Description: Driveway cross/running slope exceeds 2.0%

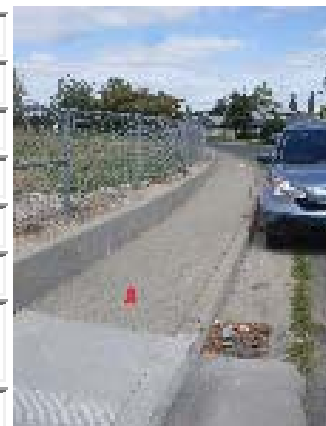
Barrier Type: Cross Slope - Existing (3.1% to 4.0%)

Code Ref: CBC 1133B.7.1.3 and ADA/ABA 403.3

As Built Meas: 287 Quantity: LF

Description: Cross slope exceeds 2.0% (3.1% to 4.0%)

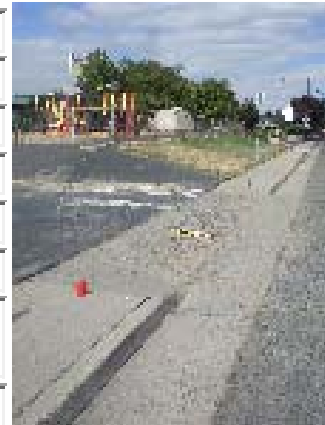
Field Date:	10/4/2010	Report Date:	10/4/2010	Barrier #:	252
Location:	Lichen Dr - West				
X Coordinate:	-121.30547				
Y Coordinate:	38.71775				
Barrier Area:	Sidewalks				
Barrier Type:	Driveway - Existing (5.0% or more)				
Code Ref:	CBC 1133B.7.1.3 and ADA/ABA 403.3

As Built Meas:	29	Quantity:	LF
Description:	Driveway cross slope exceeds 2.0% (5.0% or more)		
As Built Desc:	10.0% cross slope		
Solution:	Provide min. 48" wide level walkway through driveway		
Bar. Severity:	4 Low Severity	Cost Estimate:	\$3,625.00
Implementation Priority:	2	Facility Function:	
Implementation Phase:		Implementation Date:	
Official Responsible:			
Notes:

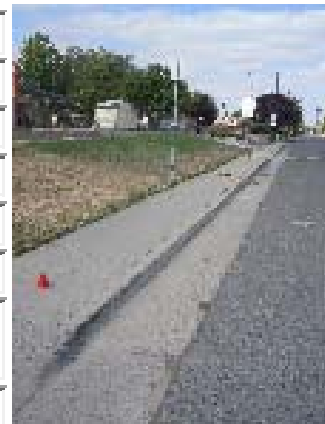
Field Date:	10/4/2010	Report Date:	10/4/2010	Barrier #:	253
Location:	Lichen Dr - West				
X Coordinate:	-121.30548				
Y Coordinate:	38.71786				
Barrier Area:	Sidewalks				
Barrier Type:	Cross Slope - Existing (5.0% or more)				
Code Ref:	CBC 1133B.7.1.3 and ADA/ABA 403.3

As Built Meas:	69	Quantity:	LF
Description:	Cross slope exceeds 2.0% (5.0% or more)		
As Built Desc:	5.4% cross slope		
Solution:	Demolish existing and construct new route		
Bar. Severity:	1 Necessary	Cost Estimate:	\$8,625.00
Implementation Priority:	2	Facility Function:	
Implementation Phase:		Implementation Date:	
Official Responsible:			
Notes:

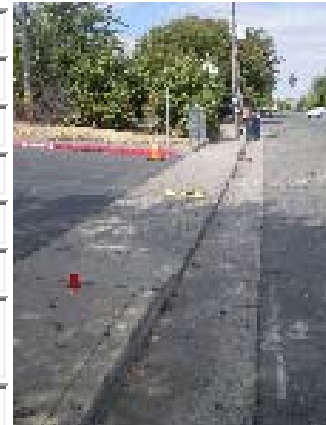
Field Date:	10/4/2010	Report Date:	10/4/2010	Barrier #:	256
Location:	Lichen Dr - West				
X Coordinate:	-121.30545				
Y Coordinate:	38.71871				
Barrier Area:	Sidewalks				
Barrier Type:	Driveway - Existing (5.0% or more)				
Code Ref:	CBC 1133B.7.1.3 and ADA/ABA 403.3

As Built Meas:	29	Quantity:	LF
Description:	Driveway cross slope exceeds 2.0% (5.0% or more)		
As Built Desc:	7.1% cross slope		
Solution:	Provide min. 48" wide level walkway through driveway		
Bar. Severity:	4 Low Severity	Cost Estimate:	\$3,625.00
Implementation Priority:	2	Facility Function:	
Implementation Phase:		Implementation Date:	
Official Responsible:			
Notes:

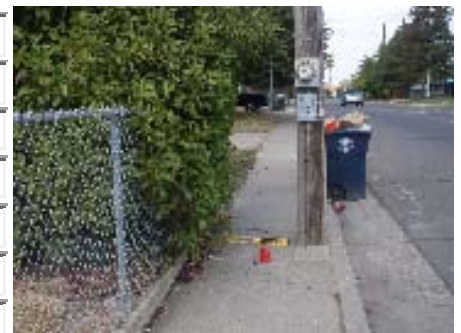
Field Date:	10/4/2010	Report Date:	10/4/2010	Barrier #:	257
Location:	Lichen Dr - West				
X Coordinate:	-121.30546				
Y Coordinate:	38.71889				
Barrier Area:	Sidewalks				
Barrier Type:	Clear Width - Existing ($\leq 31"$ or less)				
Code Ref:	CBC 1133B.7.1

As Built Meas:	1	Quantity:	LF
Description:	Pedestrian route is not min. 48" wide ($\leq 31"$ or less)		
As Built Desc:	28" clear width due to foliage		
Solution:	Trim foliage to provide min. 48" clear width		
Bar. Severity:	1 Necessary	Cost Estimate:	\$125.00
Implementation Priority:	2	Facility Function:	
Implementation Phase:		Implementation Date:	
Official Responsible:			
Notes:

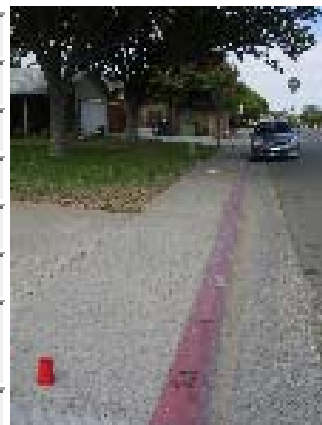
Barrier Type: Cross Slope - Existing (4.1% to 4.9%)

Description: Cross slope exceeds 2.0% (4.1% to 4.9%)

Bar. Severity: 2 Recommended

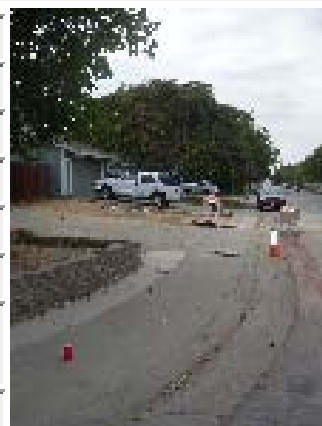
Barrier Type: Cross Slope - Existing (4.1% to 4.9%)

Description: Cross slope exceeds 2.0% (4.1% to 4.9%)

Bar. Severity: 2 Recommended

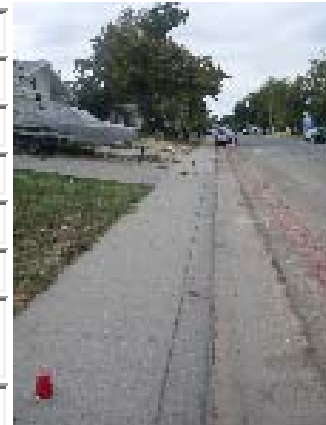
Barrier Type: Cross Slope - Existing (4.1% to 4.9%)

Description: Cross slope exceeds 2.0% (4.1% to 4.9%)

Bar. Severity: 2 Recommended

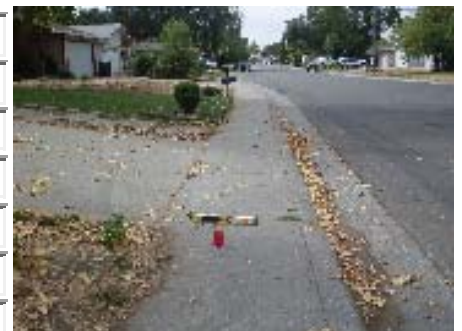
Barrier Type: Cross Slope - Existing (4.1% to 4.9%)

Description: Cross slope exceeds 2.0% (4.1% to 4.9%)

Bar. Severity: 2 Recommended

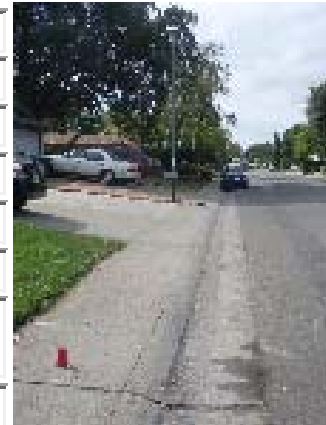
Field Date:	10/4/2010	Report Date:	10/4/2010	Barrier #:	262
Location:	Villaview Dr - South				
X Coordinate:	-121.30892				
Y Coordinate:	38.71986				
Barrier Area:	Sidewalks				
Barrier Type:	Cross Slope - Existing (4.1% to 4.9%)				
Code Ref:	CBC 1133B.7.1.3 and ADA/ABA 403.3

As Built Meas:	364	Quantity:	LF
Description:	Cross slope exceeds 2.0% (4.1% to 4.9%)		
As Built Desc:	4.6% cross slope		
Solution:	Demolish existing and construct new route		
Bar. Severity:	2 Recommended	Cost Estimate:	\$45,500.00
Implementation Priority:	4	Facility Function:	
Implementation Phase:		Implementation Date:	
Official Responsible:			
Notes:

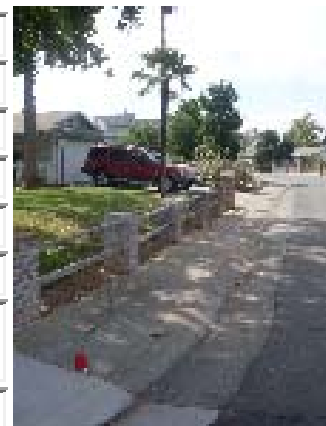
Field Date:	10/4/2010	Report Date:	10/4/2010	Barrier #:	263
Location:	Villaview Dr - South				
X Coordinate:	-121.31053				
Y Coordinate:	38.71984				
Barrier Area:	Sidewalks				
Barrier Type:	Cross Slope - Existing (5.0% or more)				
Code Ref:	CBC 1133B.7.1.3 and ADA/ABA 403.3

As Built Meas:	774	Quantity:	LF
Description:	Cross slope exceeds 2.0% (5.0% or more)		
As Built Desc:	7.4% cross slope		
Solution:	Demolish existing and construct new route		
Bar. Severity:	1 Necessary	Cost Estimate:	\$96,750.00
Implementation Priority:	4	Facility Function:	
Implementation Phase:		Implementation Date:	
Official Responsible:			
Notes:

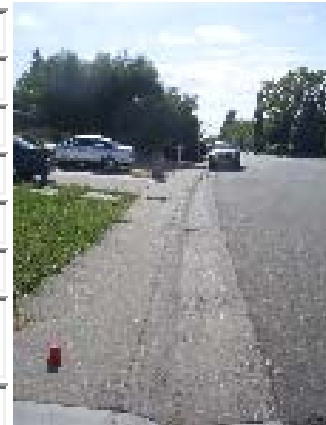
Field Date:	10/4/2010	Report Date:	10/4/2010	Barrier #:	264A
Location:	Villaview Dr - South				
X Coordinate:	-121.31274				
Y Coordinate:	38.71839				
Barrier Area:	Sidewalks				
Barrier Type:	Cross Slope - Existing (5.0% or more)				
Code Ref:	CBC 1133B.7.1.3 and ADA/ABA 403.3

As Built Meas:	179	Quantity:	LF	
Description:	Cross slope exceeds 2.0% (5.0% or more)			
As Built Desc:	5.3% cross slope			
Solution:	Demolish existing and construct new route			
Bar. Severity:	1 Necessary	Cost Estimate:	\$22,375.00	Status:
Implementation Priority:	4	Facility Function:		
Implementation Phase:		Implementation Date:		
Official Responsible:				
Notes:

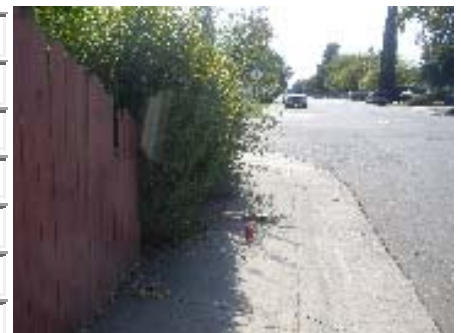
Field Date:	10/4/2010	Report Date:	10/4/2010	Barrier #:	264B
Location:	Villaview Dr - South				
X Coordinate:	-121.31317				
Y Coordinate:	38.71808				
Barrier Area:	Sidewalks				
Barrier Type:	Clear Width - Existing ($\leq 31"$ or less)				
Code Ref:	CBC 1133B.7.1

As Built Meas:	1	Quantity:	LF	
Description:	Pedestrian route is not min. 48" wide ($\leq 31"$ or less)			
As Built Desc:	28" clear width due to foliage			
Solution:	Trim foliage to provide min. 48" clear width			
Bar. Severity:	1 Necessary	Cost Estimate:	\$125.00	Status:
Implementation Priority:	4	Facility Function:		
Implementation Phase:		Implementation Date:		
Official Responsible:				
Notes:

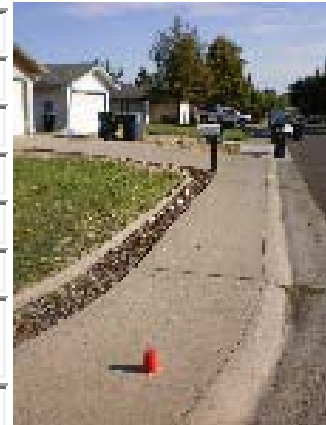
Barrier Type: Cross Slope - Existing (4.1% to 4.9%)

Description: Cross slope exceeds 2.0% (4.1% to 4.9%)

Bar. Severity: 2 Recommended

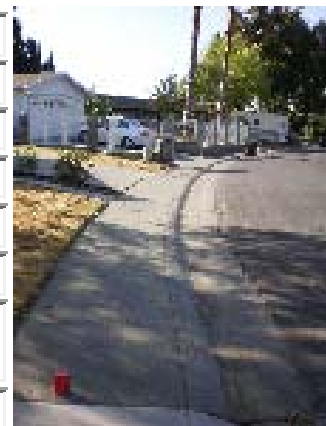
Barrier Type: Cross Slope - Existing (4.1% to 4.9%)

Description: Cross slope exceeds 2.0% (4.1% to 4.9%)

Bar. Severity: 2 Recommended

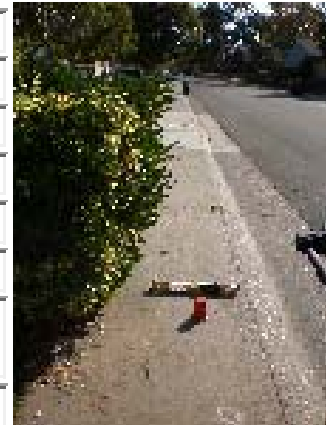
Barrier Type: Clear Width - Existing (32" to 35")

Description: Pedestrian route is not min. 48" wide (32" to 35")

Bar. Severity: 2 Recommended

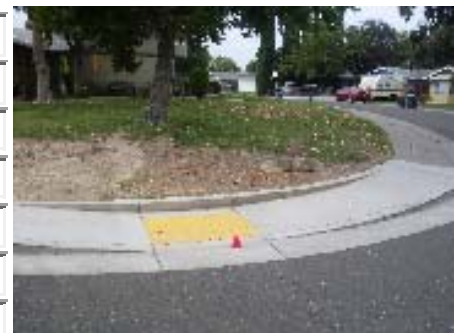
Barrier Type: 12" Grooves - New Construction

Description: 12" grooves at top of curb ramp are not level (>5.0%)

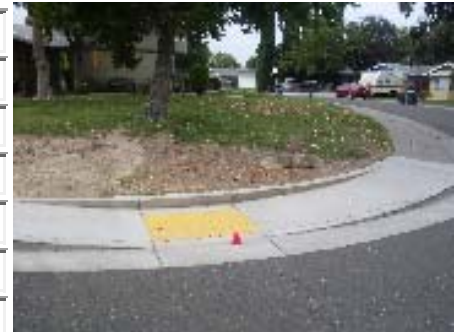
Barrier Type: Parallel Ramp Landing - New Construction

Description: Curb ramp landing or pan not level (3.1% to 4.0%)

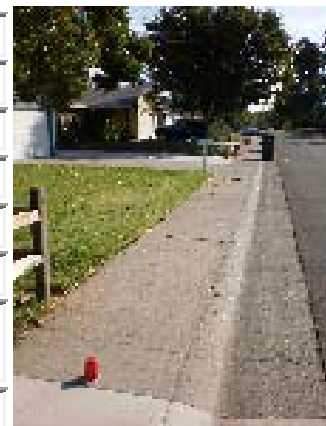
Barrier Type: Cross Slope - Existing (4.1% to 4.9%)

Description: Cross slope exceeds 2.0% (4.1% to 4.9%)

Bar. Severity: 2 Recommended

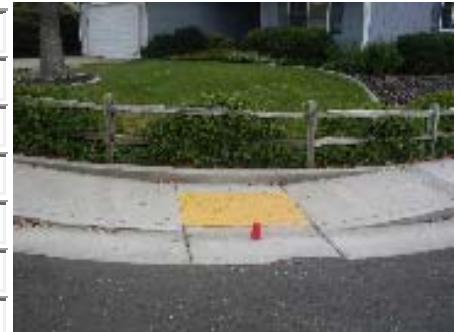
Field Date:	10/5/2010	Report Date:	10/5/2010	Barrier #:	273
Location:	Mistletoe Wy and Mannerly Wy - Corner D				
X Coordinate:	-121.30847				
Y Coordinate:	38.71914				
Barrier Area:	Curb Ramps				
Barrier Type:	Perpendicular Ramp Landing - New Construction				
Code Ref:	CBC 1127B.5.4 and ADA/ABA 406.4

As Built Meas:	1	Quantity:	EACH
Description:	Curb ramp landing or pan not level (>5.0% or more)		
As Built Desc:	6.2% landing slope		
Solution:	Demolish existing and construct new transition		
Bar. Severity:	1 Necessary	Cost Estimate:	\$250.00
Implementation Priority:	4	Facility Function:	
Implementation Phase:		Implementation Date:	
Official Responsible:			
Notes:	Three - way intersection corners A,C,D. Corners A,C compliant

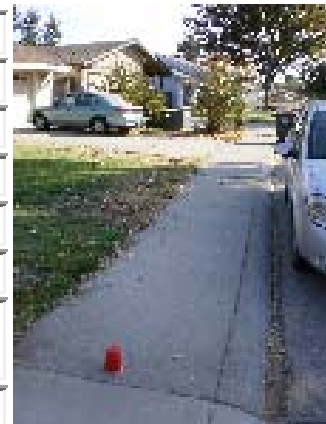
Field Date:	10/5/2010	Report Date:	10/5/2010	Barrier #:	274
Location:	Mannerly Wy - North				
X Coordinate:	-121.30841				
Y Coordinate:	38.71921				
Barrier Area:	Sidewalks				
Barrier Type:	Cross Slope - Existing (4.1% to 4.9%)				
Code Ref:	CBC 1133B.7.1.3 and ADA/ABA 403.3

As Built Meas:	586	Quantity:	LF
Description:	Cross slope exceeds 2.0% (4.1% to 4.9%)		
As Built Desc:	4.1% cross slope		
Solution:	Demolish existing and construct new route		
Bar. Severity:	2 Recommended	Cost Estimate:	\$73,250.00
Implementation Priority:	4	Facility Function:	
Implementation Phase:		Implementation Date:	
Official Responsible:			
Notes:

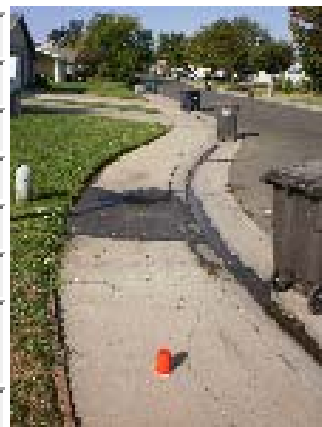
Barrier Type: Cross Slope - Existing (5.0% or more)

Description: Cross slope exceeds 2.0% (5.0% or more)

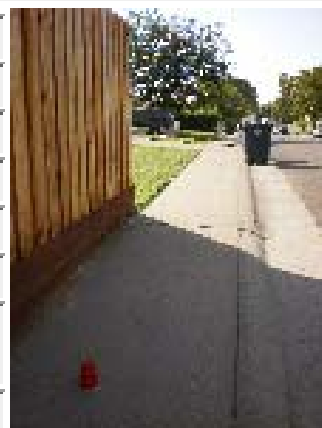
Barrier Type: Cross Slope - Existing (4.1% to 4.9%)

Description: Cross slope exceeds 2.0% (4.1% to 4.9%)

Bar. Severity: 2 Recommended

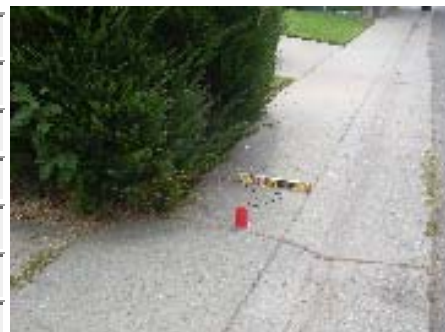
Barrier Type: Clear Width - Existing ($\leq 31"$ or less)

Description: Pedestrian route is not min. 48" wide ($\leq 31"$ or less)

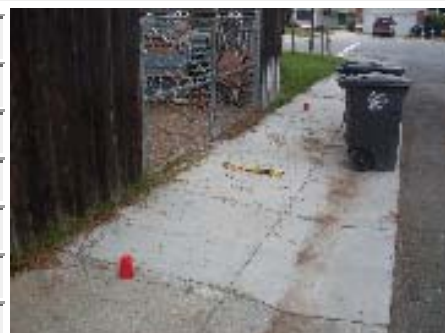
Barrier Type: Driveway - New Construction

Description: Driveway cross/running slope exceeds 2.0%
