DRAFT ADA TRANSITION PLAN UPDATE
NEIGHBORHOOD AREA 1 NORTHWEST
SEPTEMBER 20, 2011

CITY OF CITRUS HEIGHTS

The Northwest Neighborhood Association

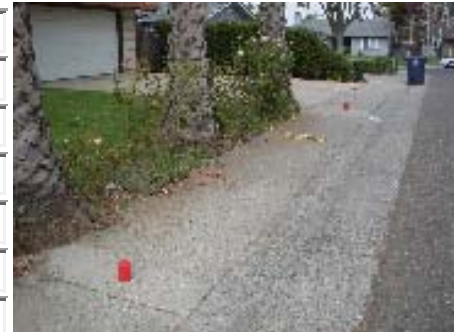
Barrier Type: Cross Slope - Existing (4.1% to 4.9%)

Description: Cross slope exceeds 2.0% (4.1% to 4.9%)

Bar. Severity: 2 Recommended

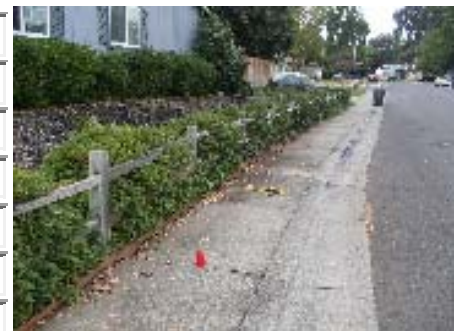
Barrier Type: Cross Slope - Existing (4.1% to 4.9%)

Description: Cross slope exceeds 2.0% (4.1% to 4.9%)

Bar. Severity: 2 Recommended

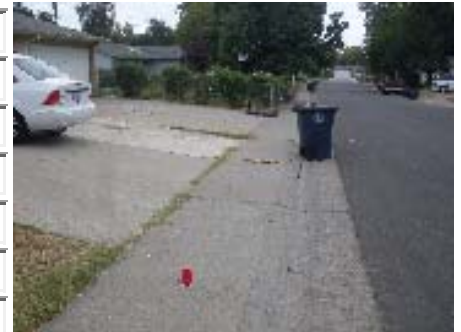
Field Date:	10/5/2010	Report Date:	10/5/2010	Barrier #:	282A
Location:	Radford St - East				
X Coordinate:	-121.30927				
Y Coordinate:	38.71888				
Barrier Area:	Sidewalks				
Barrier Type:	Cross Slope - Existing (5.0% or more)				
Code Ref:	CBC 1133B.7.1.3 and ADA/ABA 403.3

As Built Meas:	482	Quantity:	LF
Description:	Cross slope exceeds 2.0% (5.0% or more)		
As Built Desc:	9.5% cross slope		
Solution:	Demolish existing and construct new route		
Bar. Severity:	1 Necessary	Cost Estimate:	\$60,250.00
Implementation Priority:	4	Facility Function:	
Implementation Phase:		Implementation Date:	
Official Responsible:			
Notes:

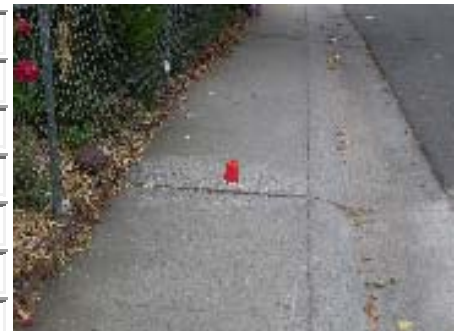
Field Date:	10/5/2010	Report Date:	10/5/2010	Barrier #:	282B
Location:	Radford St - East				
X Coordinate:	-121.30927				
Y Coordinate:	38.71867				
Barrier Area:	Sidewalks				
Barrier Type:	Abrupt Change in Level - > 1/2"				
Code Ref:	CBC 1133B.7.1 and ADA/ABA 303.3

As Built Meas:	4	Quantity:	LF
Description:	Change in level greater than 1/2"		
As Built Desc:	1" lip in sidewalk surface		
Solution:	Grind or repair sidewalk to remove trip hazard		
Bar. Severity:	1 Necessary	Cost Estimate:	\$1,000.00
Implementation Priority:	4	Facility Function:	
Implementation Phase:		Implementation Date:	
Official Responsible:			
Notes:

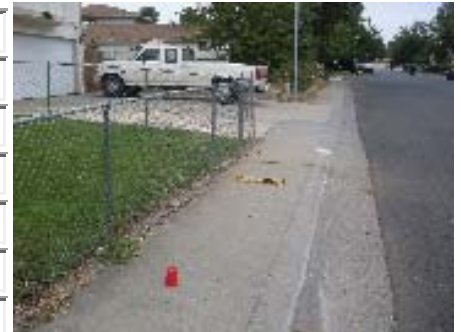
Field Date:	10/5/2010	Report Date:	10/5/2010	Barrier #:	283
Location:	Radford St - West				
X Coordinate:	-121.30941				
Y Coordinate:	38.71750				
Barrier Area:	Sidewalks				
Barrier Type:	Cross Slope - Existing (4.1% to 4.9%)				
Code Ref:	CBC 1133B.7.1.3 and ADA/ABA 403.3

As Built Meas:	159	Quantity:	LF
Description:	Cross slope exceeds 2.0% (4.1% to 4.9%)		
As Built Desc:	4.8% cross slope		
Solution:	Demolish existing and construct new route		
Bar. Severity:	2 Recommended	Cost Estimate:	\$19,875.00
Implementation Priority:	4	Facility Function:	
Implementation Phase:		Implementation Date:	
Official Responsible:			
Notes:

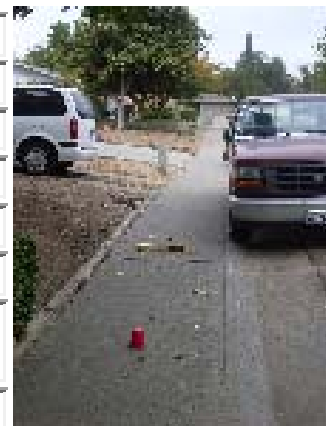
Field Date:	10/5/2010	Report Date:	10/5/2010	Barrier #:	284
Location:	Radford St - West				
X Coordinate:	-121.30937				
Y Coordinate:	38.71823				
Barrier Area:	Sidewalks				
Barrier Type:	Cross Slope - Existing (4.1% to 4.9%)				
Code Ref:	CBC 1133B.7.1.3 and ADA/ABA 403.3

As Built Meas:	247	Quantity:	LF
Description:	Cross slope exceeds 2.0% (4.1% to 4.9%)		
As Built Desc:	4.7% cross slope		
Solution:	Demolish existing and construct new route		
Bar. Severity:	2 Recommended	Cost Estimate:	\$30,875.00
Implementation Priority:	4	Facility Function:	
Implementation Phase:		Implementation Date:	
Official Responsible:			
Notes:

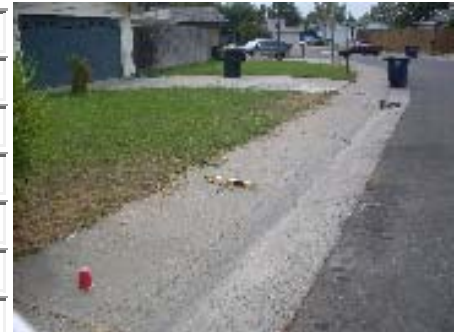
Barrier Type: Cross Slope - Existing (5.0% or more)

Description: Cross slope exceeds 2.0% (5.0% or more)

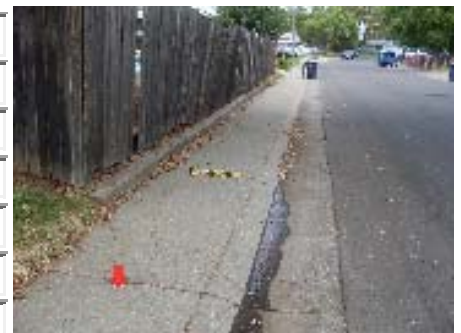
Barrier Type: Cross Slope - Existing (4.1% to 4.9%)

Description: Cross slope exceeds 2.0% (4.1% to 4.9%)

Bar. Severity: 2 Recommended Cost Estimate: \$40,125.00 Status:

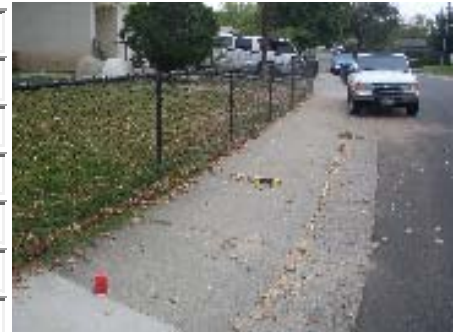
Field Date:	10/5/2010	Report Date:	10/5/2010	Barrier #:	287A
Location:	Twining Wy - South				
X Coordinate:	-121.30949				
Y Coordinate:	38.71798				
Barrier Area:	Sidewalks				
Barrier Type:	Cross Slope - Existing (5.0% or more)				
Code Ref:	CBC 1133B.7.1.3 and ADA/ABA 403.3

As Built Meas:	183	Quantity:	LF
Description:	Cross slope exceeds 2.0% (5.0% or more)		
As Built Desc:	7.4% cross slope		
Solution:	Demolish existing and construct new route		
Bar. Severity:	1 Necessary	Cost Estimate:	\$22,875.00
Implementation Priority:	4	Facility Function:	
Implementation Phase:		Implementation Date:	
Official Responsible:			
Notes:

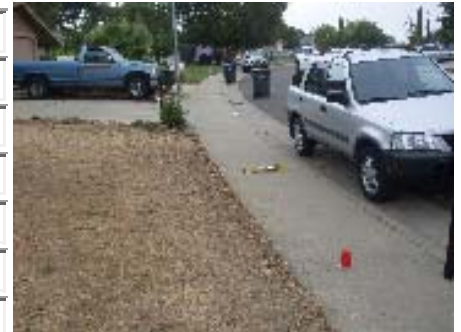
Barrier Type: Cross Slope - Existing (5.0% or more)

Code Ref: CBC 1133B.7.1.3 and ADA/ABA 403.3

As Built Meas: 74 Quantity: LF

Description: Cross slope exceeds 2.0% (5.0% or more)

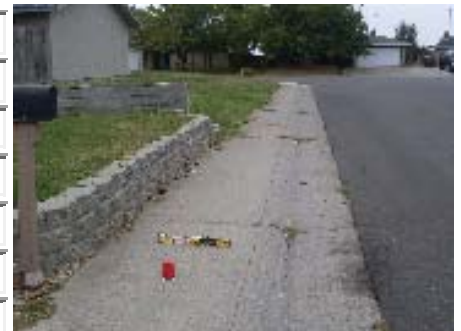
Barrier Type: Cross Slope - Existing (5.0% or more)

Code Ref: CBC 1133B.7.1.3 and ADA/ABA 403.3

As Built Meas: 107 Quantity: LF

Description: Cross slope exceeds 2.0% (5.0% or more)

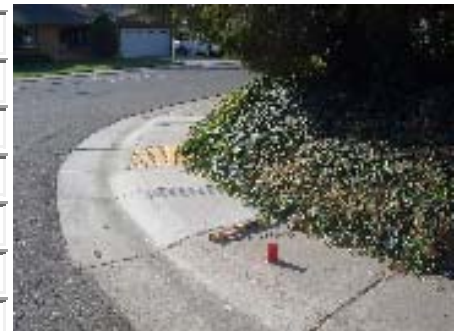
Field Date:	10/5/2010	Report Date:	10/5/2010	Barrier #:	291
Location:	Butternut Dr - South				
X Coordinate:	-121.31355				
Y Coordinate:	38.71798				
Barrier Area:	Sidewalks				
Barrier Type:	Clear Width - Existing ($\leq 31"$ or less)				
Code Ref:	CBC 1133B.7.1

As Built Meas:	1	Quantity:	LF
Description:	Pedestrian route is not min. 48" wide ($\leq 31"$ or less)		
As Built Desc:	24" clear width due to foliage		
Solution:	Trim foliage to provide min. 48" clear width		
Bar. Severity:	1 Necessary	Cost Estimate:	\$125.00
Implementation Priority:	2	Facility Function:	
Implementation Phase:		Implementation Date:	
Official Responsible:

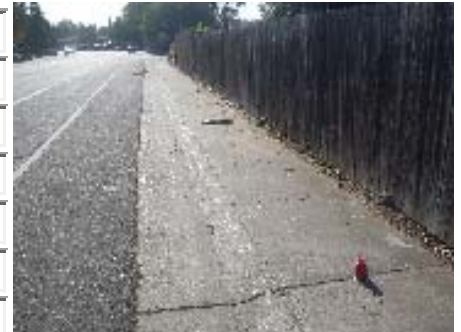
Barrier Type: Cross Slope - Existing (3.1% to 4.0%)

Code Ref: CBC 1133B.7.1.3 and ADA/ABA 403.3

As Built Meas: 146 Quantity: LF

Description: Cross slope exceeds 2.0% (3.1% to 4.0%)

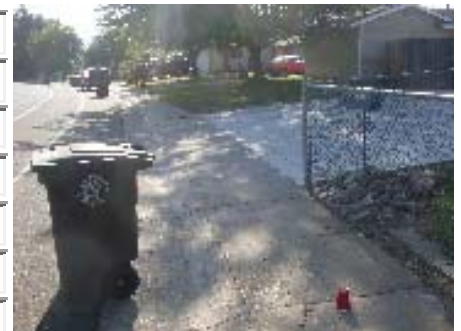
Barrier Type: Cross Slope - Existing (5.0% or more)

Code Ref: CBC 1133B.7.1.3 and ADA/ABA 403.3

As Built Meas: 328 Quantity: LF

Description: Cross slope exceeds 2.0% (5.0% or more)

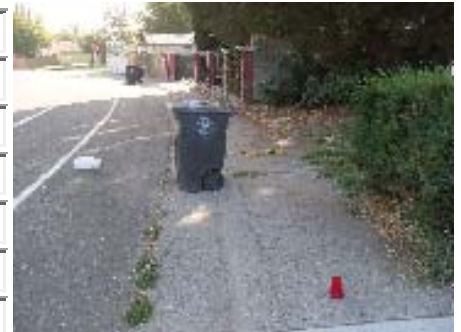
Field Date:	10/5/2010	Report Date:	10/5/2010	Barrier #:	294
Location:	Butternut Dr - South				
X Coordinate:	-121.31112				
Y Coordinate:	38.71698				
Barrier Area:	Sidewalks				
Barrier Type:	Cross Slope - Existing (5.0% or more)				
Code Ref:	CBC 1133B.7.1.3 and ADA/ABA 403.3

As Built Meas:	182	Quantity:	LF
Description:	Cross slope exceeds 2.0% (5.0% or more)		
As Built Desc:	6.8% cross slope		
Solution:	Demolish existing and construct new route		
Bar. Severity:	1 Necessary	Cost Estimate:	\$22,750.00
Implementation Priority:	2	Facility Function:	
Implementation Phase:		Implementation Date:	
Official Responsible:

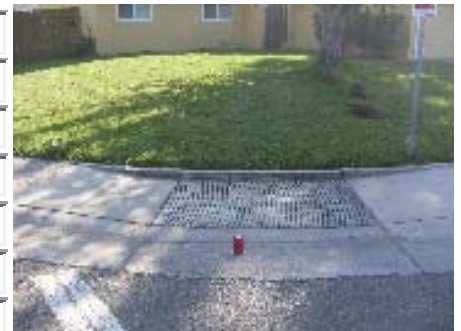
Field Date:	10/5/2010	Report Date:	10/5/2010	Barrier #:	295
Location:	Butternut Dr and Zenith Dr - Corner C				
X Coordinate:	-121.31025				
Y Coordinate:	38.71704				
Barrier Area:	Curb Ramps				
Barrier Type:	Detectable Warnings - Truncated Domes				
Code Ref:	CBC 1127B.5.7 and ADA/ABA 705.1.3

As Built Meas:	1	Quantity:	EACH
Description:	No truncated domes provided at curb ramp		
As Built Desc:	No detectable warnings at curb ramp		
Solution:	Provide compliant truncated domes		
Bar. Severity:	2 Recommended	Cost Estimate:	\$1,400.00
Implementation Priority:	2	Facility Function:	
Implementation Phase:		Implementation Date:	
Official Responsible:

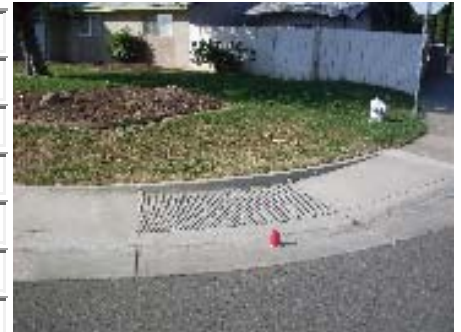
Field Date:	10/5/2010	Report Date:	10/5/2010	Barrier #:	296A
Location:	Butternut Dr and Zenith Dr - Corner D				
X Coordinate:	-121.31044				
Y Coordinate:	38.71700				
Barrier Area:	Curb Ramps				
Barrier Type:	12" Grooves - Existing (>5.0%)				
Code Ref:	CBC 1127B.5.6

As Built Meas:	1	Quantity:	EACH		
Description:	12" grooves at top of curb ramp are not level (>5.0%)				
As Built Desc:	7.0% at 12" grooves				
Solution:	Demolish existing and construct new curb ramp				
Bar. Severity:	1 Necessary	Cost Estimate:	\$2,500.00	Status:	
Implementation Priority:	2	Facility Function:			
Implementation Phase:		Implementation Date:			
Official Responsible:					
Notes:	Two - way intersection corners C,D

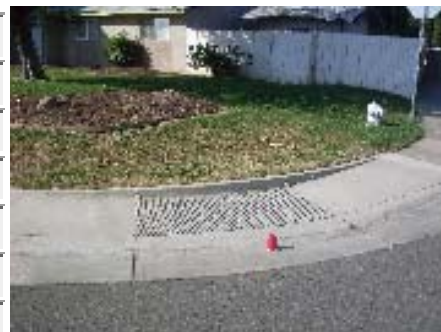
Barrier Type: Gutter Slope - New Construction

Code Ref: CBC 1127B.5.3 and ADA/ABA 406.2

As Built Meas: 6 Quantity: SF

Description: Gutter slope exceeds 5.0%

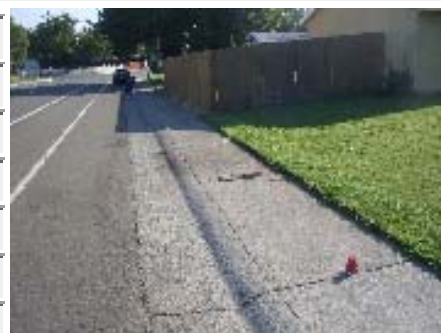
Barrier Type: Cross Slope - Existing (5.0% or more)

Code Ref: CBC 1133B.7.1.3 and ADA/ABA 403.3

As Built Meas: 737 Quantity: LF

Description: Cross slope exceeds 2.0% (5.0% or more)

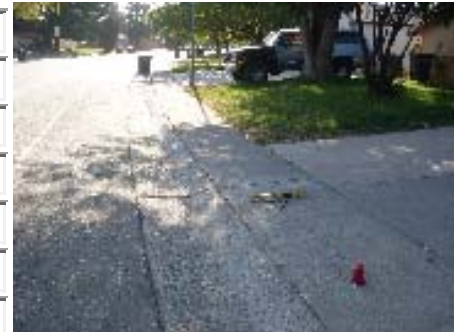
Field Date:	10/5/2010	Report Date:	10/5/2010	Barrier #:	298A
Location:	Butternut Dr - South				
X Coordinate:	-121.30725				
Y Coordinate:	38.71698				
Barrier Area:	Sidewalks				
Barrier Type:	Cross Slope - Existing (5.0% or more)				
Code Ref:	CBC 1133B.7.1.3 and ADA/ABA 403.3

As Built Meas:	335	Quantity:	LF		
Description:	Cross slope exceeds 2.0% (5.0% or more)				
As Built Desc:	7.3% cross slope				
Solution:	Demolish existing and construct new route				
Bar. Severity:	1 Necessary	Cost Estimate:	\$41,875.00	Status:	
Implementation Priority:	2	Facility Function:			
Implementation Phase:		Implementation Date:			
Official Responsible:					
Notes:

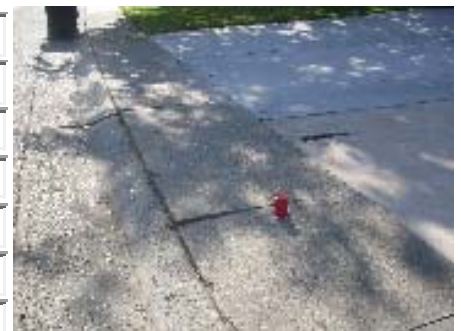
Field Date:	10/5/2010	Report Date:	10/5/2010	Barrier #:	298B
Location:	Butternut Dr - South				
X Coordinate:	-121.30711				
Y Coordinate:	38.71687				
Barrier Area:	Sidewalks				
Barrier Type:	Abrupt Change in Level - > 1/2"				
Code Ref:	CBC 1133B.7.1 and ADA/ABA 303.3

As Built Meas:	4	Quantity:	LF		
Description:	Change in level greater than 1/2"				
As Built Desc:	1" lip in sidewalk surface				
Solution:	Grind or repair sidewalk to remove trip hazard				
Bar. Severity:	1 Necessary	Cost Estimate:	\$1,000.00	Status:	
Implementation Priority:	2	Facility Function:			
Implementation Phase:		Implementation Date:			
Official Responsible:					
Notes:

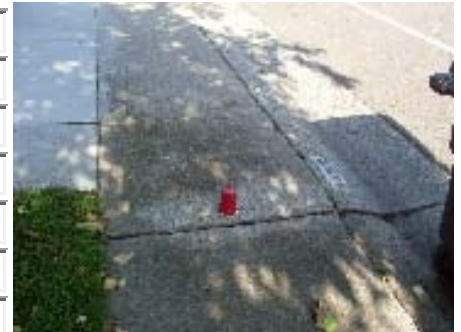
Field Date:	10/5/2010	Report Date:	10/5/2010	Barrier #:	298C
Location:	Butternut Dr - South				
X Coordinate:	-121.30702				
Y Coordinate:	38.71682				
Barrier Area:	Sidewalks				
Barrier Type:	Abrupt Change in Level - > 1/2"				
Code Ref:	CBC 1133B.7.1 and ADA/ABA 303.3

As Built Meas:	4	Quantity:	LF
Description:	Change in level greater than 1/2"		
As Built Desc:	1" lip in sidewalk surface		
Solution:	Grind or repair sidewalk to remove trip hazard		
Bar. Severity:	1 Necessary	Cost Estimate:	\$1,000.00
Implementation Priority:	2	Facility Function:	
Implementation Phase:		Implementation Date:	
Official Responsible:			
Notes:

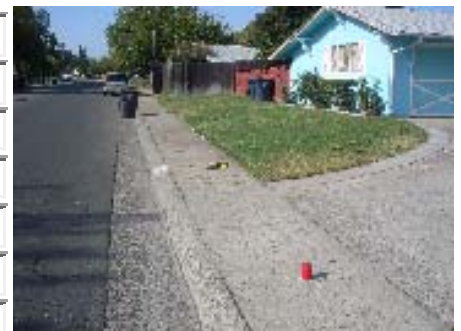
Field Date:	10/5/2010	Report Date:	10/5/2010	Barrier #:	299
Location:	Lichen Dr - West				
X Coordinate:	-121.30650				
Y Coordinate:	38.71631				
Barrier Area:	Sidewalks				
Barrier Type:	Cross Slope - Existing (5.0% or more)				
Code Ref:	CBC 1133B.7.1.3 and ADA/ABA 403.3

As Built Meas:	132	Quantity:	LF
Description:	Cross slope exceeds 2.0% (5.0% or more)		
As Built Desc:	6.1% cross slope		
Solution:	Demolish existing and construct new route		
Bar. Severity:	1 Necessary	Cost Estimate:	\$16,500.00
Implementation Priority:	2	Facility Function:	
Implementation Phase:		Implementation Date:	
Official Responsible:			
Notes:

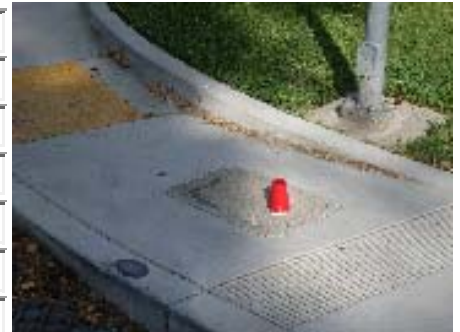
Barrier Type: Surface Condition

Code Ref: CBC 1127B.5 and ADA/ABA 403.2

As Built Meas: 3 Quantity: SF

Description: Surface is not firm and stable (cracked, broken or loose soil, etc.)

As Built Desc: Cracked concrete

Solution: Repair surface to make firm and stable

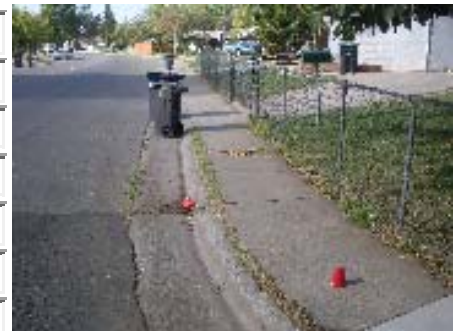
Barrier Type: Cross Slope - Existing (5.0% or more)

Code Ref: CBC 1133B.7.1.3 and ADA/ABA 403.3

As Built Meas: 193 Quantity: LF

Description: Cross slope exceeds 2.0% (5.0% or more)

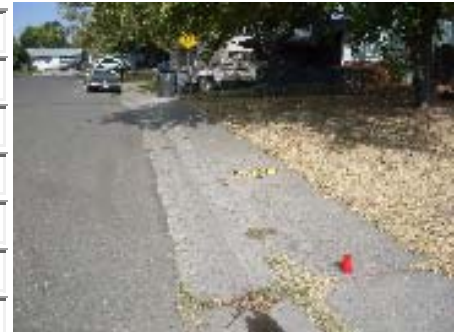
Barrier Type: Cross Slope - Existing (5.0% or more)

Code Ref: CBC 1133B.7.1.3 and ADA/ABA 403.3

As Built Meas: 188 Quantity: LF

Description: Cross slope exceeds 2.0% (5.0% or more)

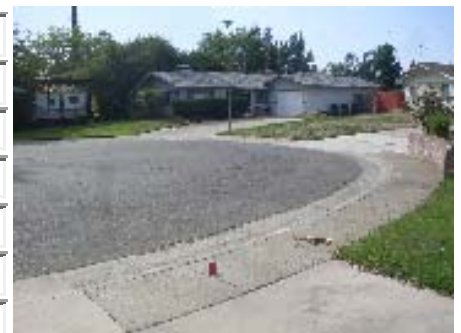
Barrier Type: Cross Slope - Existing (5.0% or more)

Code Ref: CBC 1133B.7.1.3 and ADA/ABA 403.3

As Built Meas: 144 Quantity: LF

Description: Cross slope exceeds 2.0% (5.0% or more)

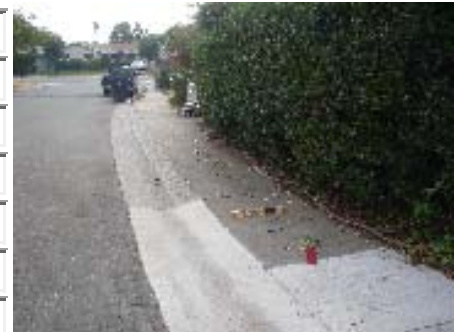
Field Date:	10/5/2010	Report Date:	10/5/2010	Barrier #:	304
Location:	Stonecorp Ct - South				
X Coordinate:	-121.30813				
Y Coordinate:	38.71576				
Barrier Area:	Sidewalks				
Barrier Type:	Cross Slope - Existing (5.0% or more)				
Code Ref:	CBC 1133B.7.1.3 and ADA/ABA 403.3

As Built Meas:	129	Quantity:	LF
Description:	Cross slope exceeds 2.0% (5.0% or more)		
As Built Desc:	5.1% cross slope		
Solution:	Demolish existing and construct new route		
Bar. Severity:	1 Necessary	Cost Estimate:	\$16,125.00
Implementation Priority:	4	Facility Function:	
Implementation Phase:		Implementation Date:	
Official Responsible:			
Notes:

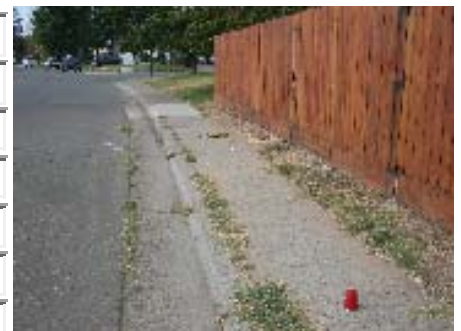
Field Date:	10/5/2010	Report Date:	10/5/2010	Barrier #:	305
Location:	Lichen Dr - West				
X Coordinate:	-121.30789				
Y Coordinate:	38.71534				
Barrier Area:	Sidewalks				
Barrier Type:	Cross Slope - Existing (5.0% or more)				
Code Ref:	CBC 1133B.7.1.3 and ADA/ABA 403.3

As Built Meas:	126	Quantity:	LF
Description:	Cross slope exceeds 2.0% (5.0% or more)		
As Built Desc:	5.4% cross slope		
Solution:	Demolish existing and construct new route		
Bar. Severity:	1 Necessary	Cost Estimate:	\$15,750.00
Implementation Priority:	2	Facility Function:	
Implementation Phase:		Implementation Date:	
Official Responsible:			
Notes:

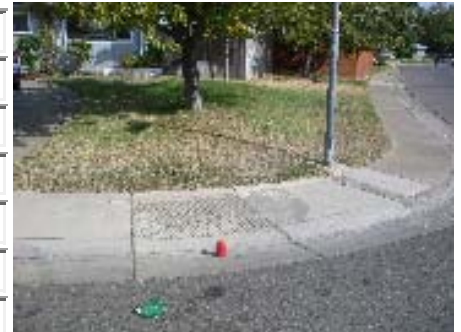
Barrier Type: Lip - Bottom of Ramp at Flow Line

Code Ref: CBC 1127B.5.3 and ADA/ABA 303.3

As Built Meas: 1 Quantity: EACH

Description: Transition at ramp bottom (flow line) is not flush and free of any lip

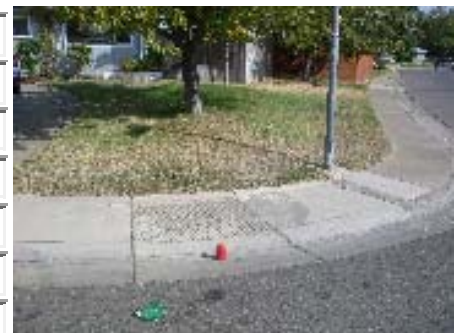
Barrier Type: Detectable Warnings - Truncated Domes

Code Ref: CBC 1127B.5.7 and ADA/ABA 705.1.3

As Built Meas: 1 Quantity: EACH

Description: No truncated domes provided at curb ramp

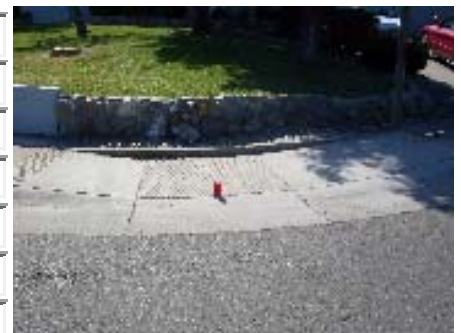
Barrier Type: Detectable Warnings - Truncated Domes

Code Ref: CBC 1127B.5.7 and ADA/ABA 705.1.3

As Built Meas: 1 Quantity: EACH

Description: No truncated domes provided at curb ramp

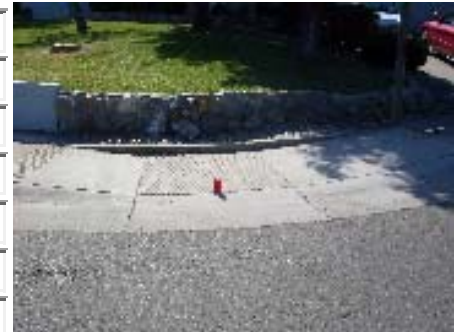
Barrier Type: 12" Grooves - Existing (>5.0%)

Code Ref: CBC 1127B.5.6

As Built Meas: 1 Quantity: EACH

Description: 12" grooves at top of curb ramp are not level (>5.0%)

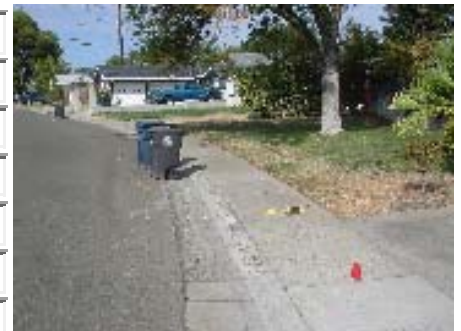
Barrier Type: Cross Slope - Existing (5.0% or more)

Code Ref: CBC 1133B.7.1.3 and ADA/ABA 403.3

As Built Meas: 280 Quantity: LF

Description: Cross slope exceeds 2.0% (5.0% or more)

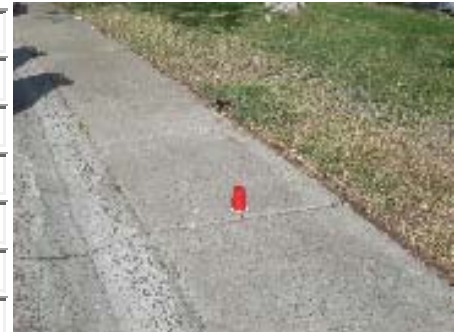
Field Date:	10/5/2010	Report Date:	10/5/2010	Barrier #:	308B
Location:	Outlook Dr - North				
X Coordinate:	-121.30827				
Y Coordinate:	38.71510				
Barrier Area:	Sidewalks				
Barrier Type:	Abrupt Change in Level - > 1/2"				
Code Ref:	N/A

As Built Meas:	4	Quantity:	LF
Description:	Change in level greater than 1/2"		
As Built Desc:	1/2" lip in sidewalk surface		
Solution:	Grind or repair sidewalk to remove trip hazard		
Bar. Severity:	1 Necessary	Cost Estimate:	\$1,000.00
Implementation Priority:	3	Facility Function:	
Implementation Phase:		Implementation Date:	
Official Responsible:			
Notes:

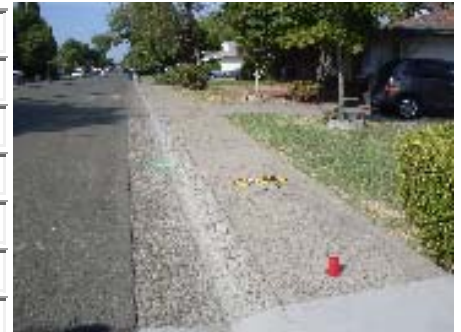
Barrier Type: Cross Slope - Existing (5.0% or more)

Code Ref: CBC 1133B.7.1.3 and ADA/ABA 403.3

As Built Meas: 550 Quantity: LF

Description: Cross slope exceeds 2.0% (5.0% or more)

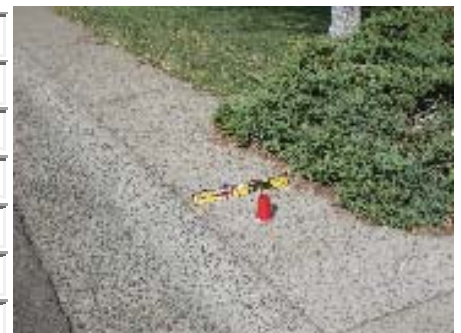
Barrier Type: Clear Width - Existing ($\leq 31"$ or less)

Code Ref: CBC 1133B.7.1

As Built Meas: 1 Quantity: LF

Description: Pedestrian route is not min. 48" wide ($\leq 31"$ or less)

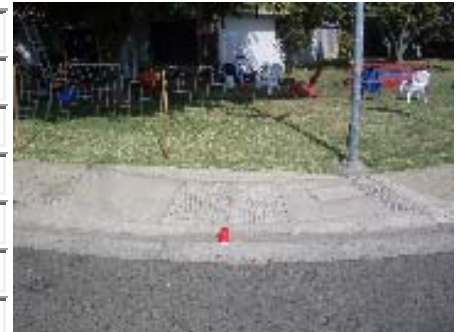
Field Date:	10/5/2010	Report Date:	10/5/2010	Barrier #:	311A
Location:	Outlook Dr and Zenith Dr - Corner A				
X Coordinate:	-121.31167				
Y Coordinate:	38.71509				
Barrier Area:	Curb Ramps				
Barrier Type:	Running Slope - Existing (9.5% or more)				
Code Ref:	CBC 1127B.5.3 and ADA/ABA 406.1

As Built Meas:	1	Quantity:	EACH
Description:	Ramp run cross slope exceeds 2.0% (9.5% or more)		
As Built Desc:	11.5% running slope		
Solution:	Demolish existing and construct new curb ramp		
Bar. Severity:	1 Necessary	Cost Estimate:	\$2,500.00
Implementation Priority:	3	Facility Function:	
Implementation Phase:		Implementation Date:	
Official Responsible:			
Notes:	Four - way intersection corners A,B,C,D

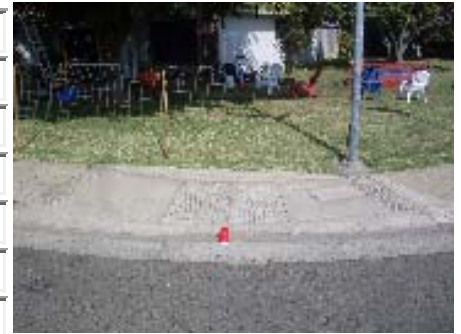
Barrier Type: Detectable Warnings - Truncated Domes

Code Ref: CBC 1127B.5.7 and ADA/ABA 705.1.3

As Built Meas: 1 Quantity: EACH

Description: No truncated domes provided at curb ramp

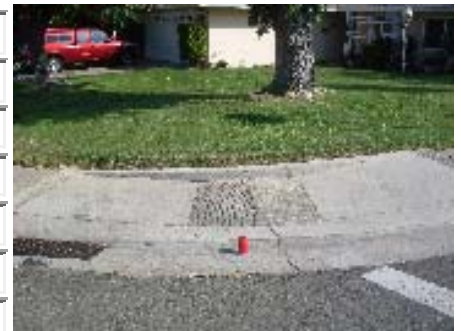
Barrier Type: Running Slope - Existing (9.5% or more)

Code Ref: CBC 1127B.5.3 and ADA/ABA 406.1

As Built Meas: 1 Quantity: EACH

Description: Ramp run cross slope exceeds 2.0% (9.5% or more)

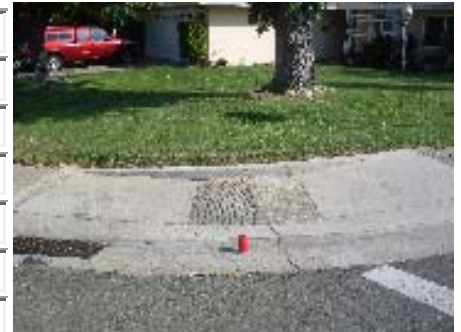
Field Date:	10/5/2010	Report Date:	10/5/2010	Barrier #:	312B
Location:	Outlook Dr and Zenith Dr - Corner B				
X Coordinate:	-121.31144				
Y Coordinate:	38.71509				
Barrier Area:	Curb Ramps				
Barrier Type:	Parallel Ramp Landing - Existing (4.1% to 4.9%)				
Code Ref:	CBC 1127B.5.4 and ADA/ABA 406.4

As Built Meas:	1	Quantity:	EACH
Description:	Curb ramp landing or pan not level(4.1% to 4.9%)		
As Built Desc:	4.7% landing slope		
Solution:	Demolish existing and construct new transition		
Bar. Severity:	2 Recommended	Cost Estimate:	\$0.00
Implementation Priority:	3	Facility Function:	
Implementation Phase:		Implementation Date:	
Official Responsible:			
Notes:	Four - way intersection corners A,B,C,D

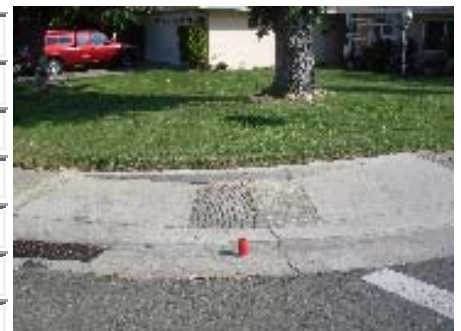
Field Date:	10/5/2010	Report Date:	10/5/2010	Barrier #:	312C
Location:	Outlook Dr and Zenith Dr - Corner B				
X Coordinate:	-121.31144				
Y Coordinate:	38.71509				
Barrier Area:	Curb Ramps				
Barrier Type:	Detectable Warnings - Truncated Domes				
Code Ref:	CBC 1127B.5.7 and ADA/ABA 705.1.3

As Built Meas:	1	Quantity:	EACH
Description:	No truncated domes provided at curb ramp		
As Built Desc:	No detectable warnings at curb ramp		
Solution:	Provide compliant truncated domes		
Bar. Severity:	2 Recommended	Cost Estimate:	\$0.00
Implementation Priority:	3	Facility Function:	
Implementation Phase:		Implementation Date:	
Official Responsible:			
Notes:	Four - way intersection corners A,B,C,D

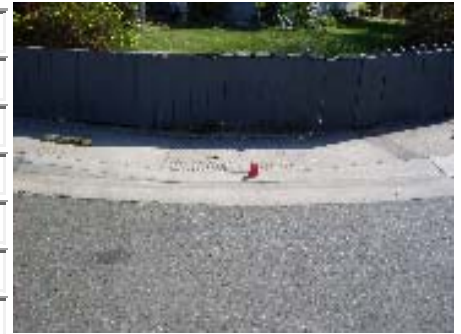
Field Date: 10/7/2010 Report Date: 10/7/2010 Barrier #: 313A

Barrier Type: Detectable Warnings - Truncated Domes

Code Ref: CBC 1127B.5.7 and ADA/ABA 705.1.3

As Built Meas: 1 Quantity: EACH

Description: No truncated domes provided at curb ramp

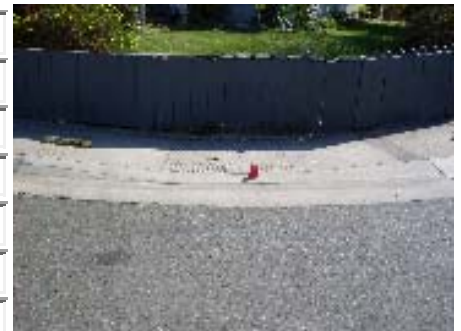
Barrier Type: 12" Grooves - Existing (2.1% to 3.0%)

Code Ref: CBC 1127B.5.6

As Built Meas: 1 Quantity: EACH

Description: 12" grooves at top of curb ramp are not level (2.1% to 3.0%)

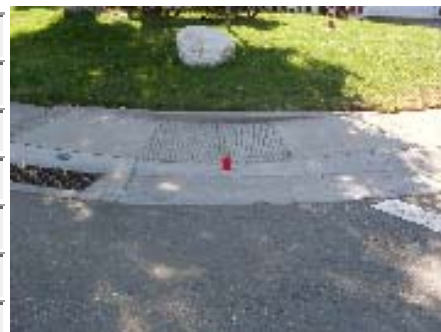
Barrier Type: Detectable Warnings - Truncated Domes

Code Ref: CBC 1127B.5.7 and ADA/ABA 705.1.3

As Built Meas: 1 Quantity: EACH

Description: No truncated domes provided at curb ramp

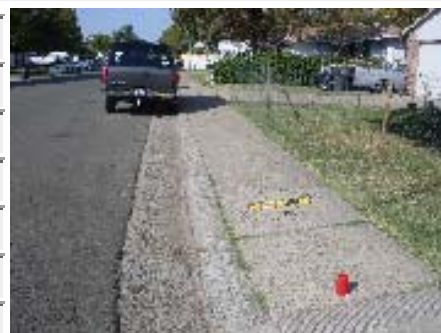
Barrier Type: Cross Slope - Existing (5.0% or more)

Code Ref: CBC 1133B.7.1.3 and ADA/ABA 403.3

As Built Meas: 282 Quantity: LF

Description: Cross slope exceeds 2.0% (5.0% or more)

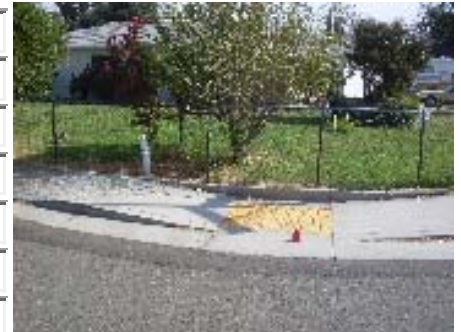
Field Date:	10/5/2010	Report Date:	10/5/2010	Barrier #:	316
Location:	Outlook Dr and Yardgate Wy - Corner B				
X Coordinate:	-121.31274				
Y Coordinate:	38.71514				
Barrier Area:	Curb Ramps				
Barrier Type:	12" Grooves - New Construction				
Code Ref:	CBC 1127B.5.6

As Built Meas:	1	Quantity:	EACH
Description:	12" grooves at top of curb ramp are not level (>5.0%)		
As Built Desc:	5.1% at 12" grooves - New Construction		
Solution:	Demolish existing and construct new curb ramp		
Bar. Severity:	1 Necessary	Cost Estimate:	\$2,500.00
Implementation Priority:	3	Facility Function:	
Implementation Phase:		Implementation Date:	
Official Responsible:			
Notes:	Two - way intersection corners A,B. Corner A compliant

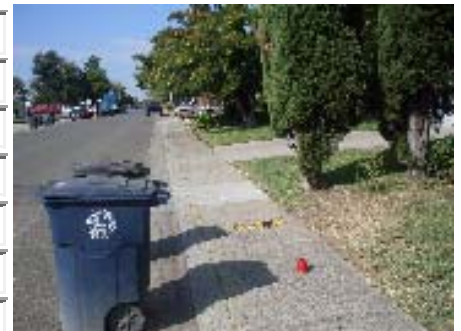
Field Date:	10/5/2010	Report Date:	10/5/2010	Barrier #:	317
Location:	Outlook Dr - North				
X Coordinate:	-121.31306				
Y Coordinate:	38.71509				
Barrier Area:	Sidewalks				
Barrier Type:	Cross Slope - Existing (5.0% or more)				
Code Ref:	CBC 1133B.7.1.3 and ADA/ABA 403.3

As Built Meas:	474	Quantity:	LF
Description:	Cross slope exceeds 2.0% (5.0% or more)		
As Built Desc:	7.2% cross slope		
Solution:	Demolish existing and construct new route		
Bar. Severity:	1 Necessary	Cost Estimate:	\$59,250.00
Implementation Priority:	3	Facility Function:	
Implementation Phase:		Implementation Date:	
Official Responsible:			
Notes:

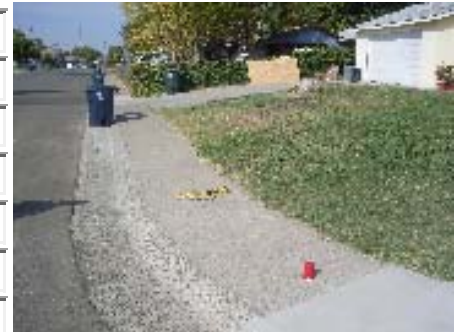
Field Date:	10/5/2010	Report Date:	10/5/2010	Barrier #:	318
Location:	Outlook Dr - North				
X Coordinate:	-121.31498				
Y Coordinate:	38.71504				
Barrier Area:	Sidewalks				
Barrier Type:	Cross Slope - Existing (5.0% or more)				
Code Ref:	CBC 1133B.7.1.3 and ADA/ABA 403.3

As Built Meas:	242	Quantity:	LF	
Description:	Cross slope exceeds 2.0% (5.0% or more)			
As Built Desc:	5.0% cross slope			
Solution:	Demolish existing and construct new route			
Bar. Severity:	1 Necessary	Cost Estimate:	\$30,250.00	Status:
Implementation Priority:	3	Facility Function:		
Implementation Phase:		Implementation Date:		
Official Responsible:				
Notes:

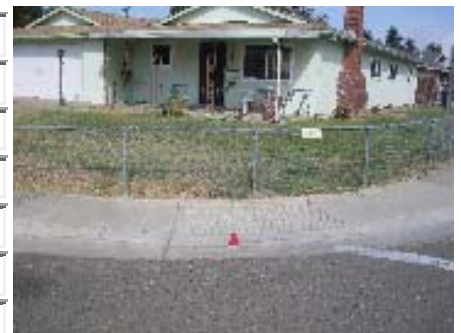
Field Date:	10/5/2010	Report Date:	10/5/2010	Barrier #:	319A
Location:	Outlook Dr and Villaview Dr - Corner A				
X Coordinate:	-121.31594				
Y Coordinate:	38.71507				
Barrier Area:	Curb Ramps				
Barrier Type:	12" Grooves - Existing (3.1% to 4.0%)				
Code Ref:	CBC 1127B.5.6

As Built Meas:	1	Quantity:	EACH	
Description:	12" grooves at top of curb ramp are not level (3.1% to 4.0%)			
As Built Desc:	3.5% at 12" grooves			
Solution:	Demolish existing and construct new curb ramp			
Bar. Severity:	3 Hindrance	Cost Estimate:	\$2,500.00	Status:
Implementation Priority:	3	Facility Function:		
Implementation Phase:		Implementation Date:		
Official Responsible:				
Notes:	Four - way intersection corners A,B,C,D

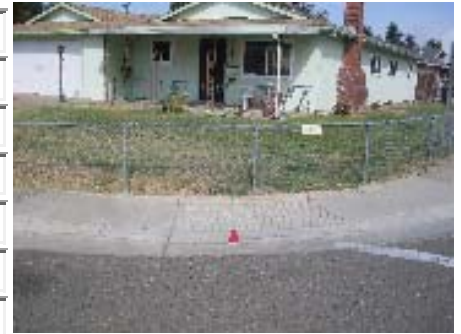
Field Date: 10/5/2010 Report Date: 10/5/2010 Barrier #: 319B

Barrier Type: Gutter Slope - Existing (8.3% or more)

Code Ref: CBC 1127B.5.3 and ADA/ABA 406.2

As Built Meas: 6 Quantity: SF

Description: Gutter slope exceeds 5.0% (8.3% or more)

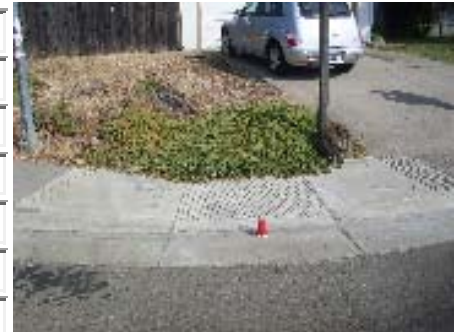
Field Date:	10/5/2010	Report Date:	10/5/2010	Barrier #:	320A
Location:	Outlook Dr and Villaview Dr - Corner B				
X Coordinate:	-121.31572				
Y Coordinate:	38.71507				
Barrier Area:	Curb Ramps				
Barrier Type:	12" Grooves - Existing (4.1% to 4.9%)				
Code Ref:	CBC 1127B.5.6

As Built Meas:	1	Quantity:	EACH
Description:	12" grooves at top of curb ramp are not level (4.1% to 4.9%)		
As Built Desc:	4.7% at 12" grooves		
Solution:	Demolish existing and construct new curb ramp		
Bar. Severity:	2 Recommended	Cost Estimate:	\$2,500.00
Implementation Priority:	3	Facility Function:	
Implementation Phase:		Implementation Date:	
Official Responsible:			
Notes:	Four - way intersection corners A,B,C,D

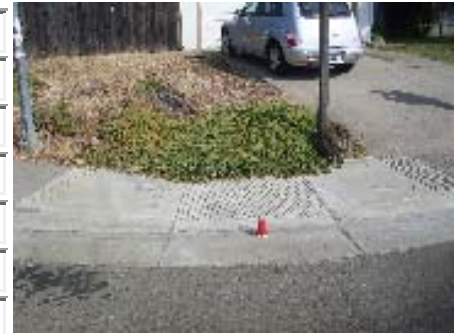
Barrier Type: Detectable Warnings - Truncated Domes

Code Ref: CBC 1127B.5.7 and ADA/ABA 705.1.3

As Built Meas: 1 Quantity: EACH

Description: No truncated domes provided at curb ramp

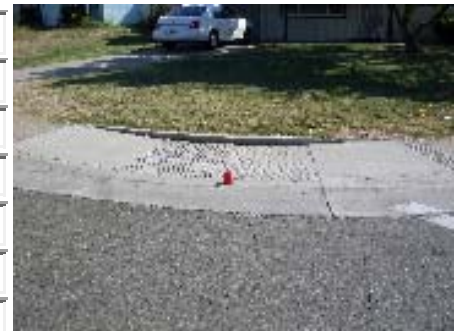
Barrier Type: 12" Grooves - Existing (>5.0%)

Code Ref: CBC 1127B.5.6

As Built Meas: 1 Quantity: EACH

Description: 12" grooves at top of curb ramp are not level (>5.0%)

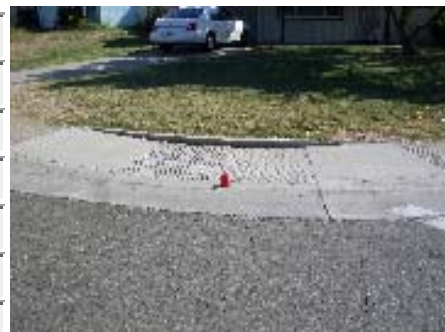
Barrier Type: Gutter Slope - Existing (6.6% to 8.2%)

Code Ref: CBC 1127B.5.3 and ADA/ABA 406.2

As Built Meas: 6 Quantity: SF

Description: Gutter slope exceeds 5.0% (6.6% to 8.2%)

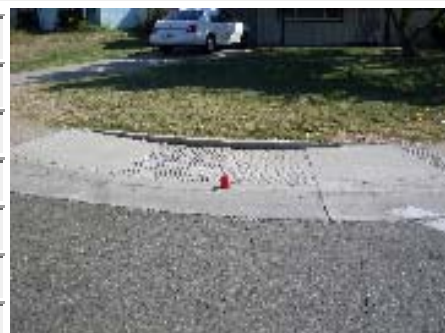
Barrier Type: Detectable Warnings - Truncated Domes

Code Ref: CBC 1127B.5.7 and ADA/ABA 705.1.3

As Built Meas: 1 Quantity: EACH

Description: No truncated domes provided at curb ramp

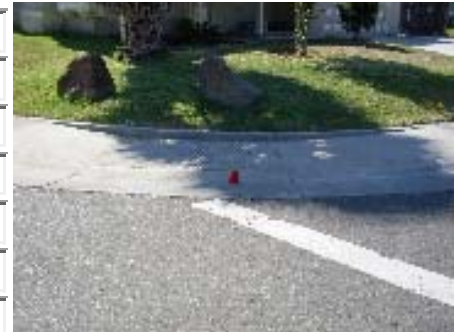
Field Date:	10/7/2010	Report Date:	10/7/2010	Barrier #:	322A
Location:	Outlook Dr and Villaview Dr - Corner D				
X Coordinate:	-121.31592				
Y Coordinate:	38.71490				
Barrier Area:	Curb Ramps				
Barrier Type:	12" Grooves - Existing (2.1% to 3.0%)				
Code Ref:	CBC 1127B.5.6

As Built Meas:	1	Quantity:	EACH
Description:	12" grooves at top of curb ramp are not level (2.1% to 3.0%)		
As Built Desc:	2.8% at 12" grooves		
Solution:	Demolish existing and construct new curb ramp		
Bar. Severity:	4 Low Severity	Cost Estimate:	\$2,500.00
Implementation Priority:	3	Facility Function:	
Implementation Phase:		Implementation Date:	
Official Responsible:			
Notes:	Four - way intersection corners A,B,C,D

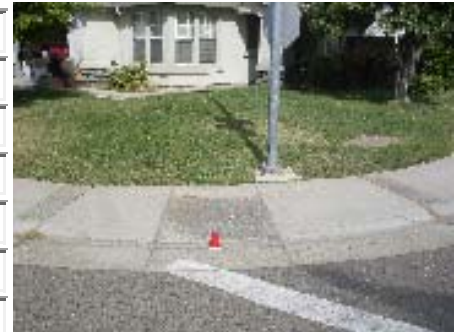
Barrier Type: Gutter Slope - Existing (5.9% - 6.5%)

Code Ref: CBC 1127B.5.3 and ADA/ABA 406.2

As Built Meas: 6 Quantity: SF

Description: Gutter slope exceeds 5.0% (5.9% - 6.5%)

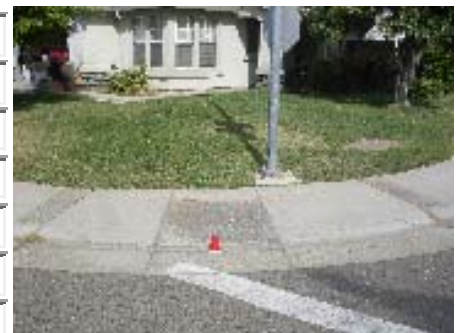
Barrier Type: Detectable Warnings - Truncated Domes

Code Ref: CBC 1127B.5.7 and ADA/ABA 705.1.3

As Built Meas: 1 Quantity: EACH

Description: No truncated domes provided at curb ramp

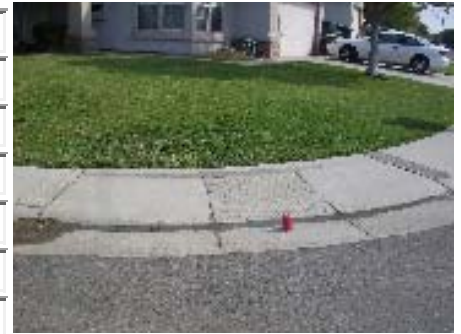
Barrier Type: 12" Grooves - Existing (3.1% to 4.0%)

Code Ref: CBC 1127B.5.6

As Built Meas: 1 Quantity: EACH

Description: 12" grooves at top of curb ramp are not level (3.1% to 4.0%)

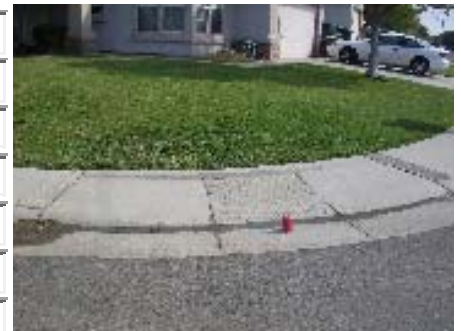
Barrier Type: Running Slope - Existing (9.5% or more)

Code Ref: CBC 1127B.5.3 and ADA/ABA 406.1

As Built Meas: 1 Quantity: EACH

Description: Ramp run cross slope exceeds 2.0% (9.5% or more)

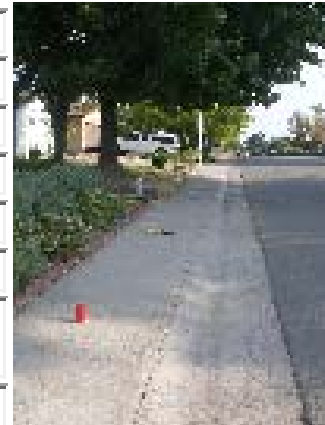
Barrier Type: Cross Slope - Existing (5.0% or more)

Code Ref: CBC 1133B.7.1.3 and ADA/ABA 403.3

As Built Meas: 626 Quantity: LF

Description: Cross slope exceeds 2.0% (5.0% or more)

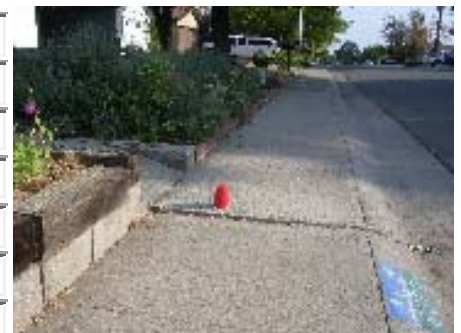
Barrier Type: Abrupt Change in Level - > 1/2"

Code Ref: CBC 1133B.7.1 and ADA/ABA 303.3

As Built Meas: 4 Quantity: LF

Description: Change in level greater than 1/2"

Solution: Grind or repair sidewalk to remove trip hazard

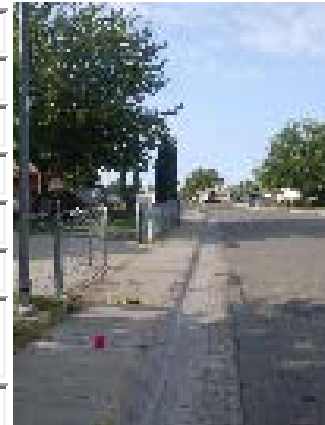
Barrier Type: Cross Slope - Existing (4.1% to 4.9%)

Code Ref: CBC 1133B.7.1.3 and ADA/ABA 403.3

As Built Meas: 105 Quantity: LF

Description: Cross slope exceeds 2.0% (4.1% to 4.9%)

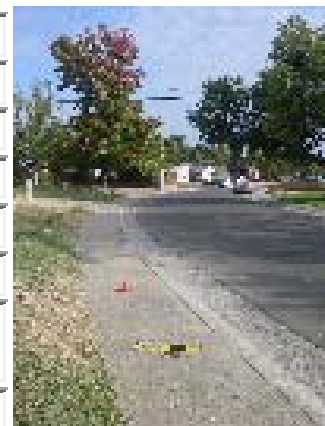
Barrier Type: Cross Slope - Existing (5.0% or more)

Code Ref: CBC 1133B.7.1.3 and ADA/ABA 403.3

As Built Meas: 429 Quantity: LF

Description: Cross slope exceeds 2.0% (5.0% or more)

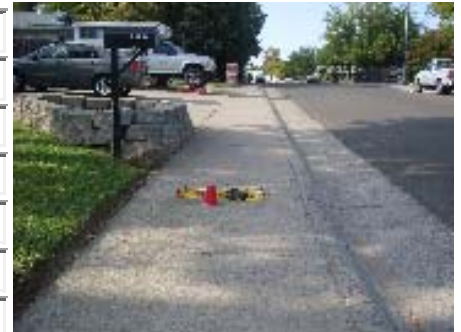
Field Date:	10/7/2010	Report Date:	10/7/2010	Barrier #:	333
Location:	Woodyard Wy - East				
X Coordinate:	-121.31274				
Y Coordinate:	38.71719				
Barrier Area:	Sidewalks				
Barrier Type:	Cross Slope - Existing (3.1% to 4.0%)				
Code Ref:	CBC 1133B.7.1.3 and ADA/ABA 403.3

As Built Meas:	12	Quantity:	LF		
Description:	Cross slope exceeds 2.0% (3.1% to 4.0%)				
As Built Desc:	3.9% cross slope				
Solution:	Demolish existing and construct new route				
Bar. Severity:	3 Hindrance	Cost Estimate:	\$1,500.00	Status:	
Implementation Priority:	4	Facility Function:			
Implementation Phase:		Implementation Date:			
Official Responsible:					
Notes:

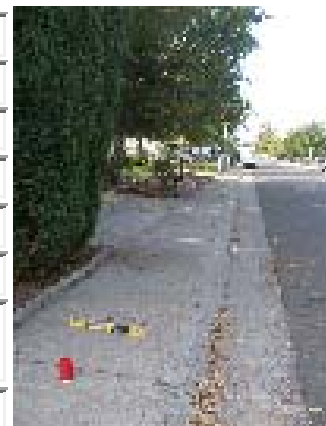
Field Date:	10/7/2010	Report Date:	10/7/2010	Barrier #:	334A
Location:	Woodyard Wy - East				
X Coordinate:	-121.31406				
Y Coordinate:	38.71610				
Barrier Area:	Sidewalks				
Barrier Type:	Cross Slope - Existing (5.0% or more)				
Code Ref:	CBC 1133B.7.1.3 and ADA/ABA 403.3

As Built Meas:	97	Quantity:	LF		
Description:	Cross slope exceeds 2.0% (5.0% or more)				
As Built Desc:	5.2% cross slope				
Solution:	Demolish existing and construct new route				
Bar. Severity:	1 Necessary	Cost Estimate:	\$12,125.00	Status:	
Implementation Priority:	4	Facility Function:			
Implementation Phase:		Implementation Date:			
Official Responsible:					
Notes:

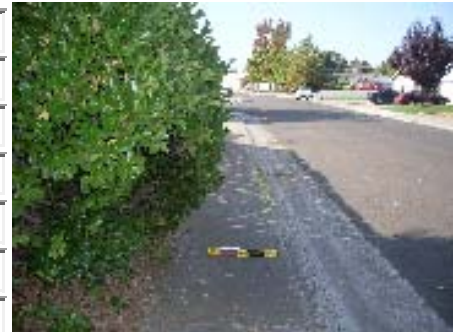
Field Date:	10/7/2010	Report Date:	10/7/2010	Barrier #:	334B
Location:	Woodyard Wy - East				
X Coordinate:	-121.31431				
Y Coordinate:	38.71590				
Barrier Area:	Sidewalks				
Barrier Type:	Clear Width - Existing ($\leq 31"$ or less)				
Code Ref:	CBC 1133B.7.1

As Built Meas:	1	Quantity:	LF
Description:	Pedestrian route is not min. 48" wide ($\leq 31"$ or less)		
As Built Desc:	28" clear width due to foliage		
Solution:	Trim foliage to provide min. 48" clear width		
Bar. Severity:	1 Necessary	Cost Estimate:	\$125.00
Implementation Priority:	4	Facility Function:	
Implementation Phase:		Implementation Date:	
Official Responsible:			
Notes:

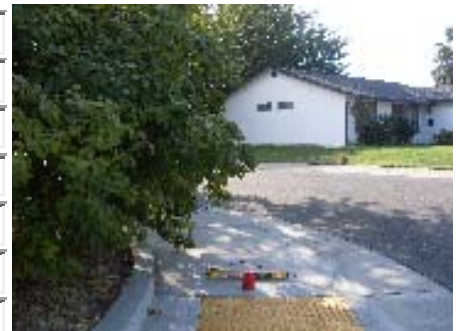
Field Date:	10/7/2010	Report Date:	10/7/2010	Barrier #:	335
Location:	Woodyard Wy and Viscount Wy - Corner B				
X Coordinate:	-121.31431				
Y Coordinate:	38.71584				
Barrier Area:	Curb Ramps				
Barrier Type:	Clear Width				
Code Ref:	CBC 1127B.5.2

As Built Meas:	1	Quantity:	EACH
Description:	Curb ramp not at least 48" wide		
As Built Desc:	31" clear width due to foliage		
Solution:	Trim foliage to provide min. 48" clear width		
Bar. Severity:	1 Necessary	Cost Estimate:	\$125.00
Implementation Priority:	4	Facility Function:	
Implementation Phase:		Implementation Date:	
Official Responsible:			
Notes:	Two - way intersection corners B,C. Corner C compliant

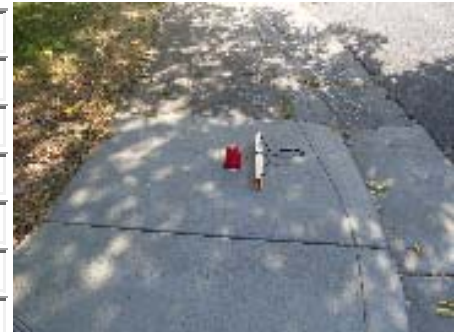
Field Date: 10/7/2010 Report Date: 10/7/2010 Barrier #: 336

Barrier Type: Running Slope (New Construction)

Code Ref: CBC 1133B.7.3 and ADA/ABA 403.3

As Built Meas: 4 Quantity: LF

Description: Running slope exceeds 5.0% where roadway slope does not

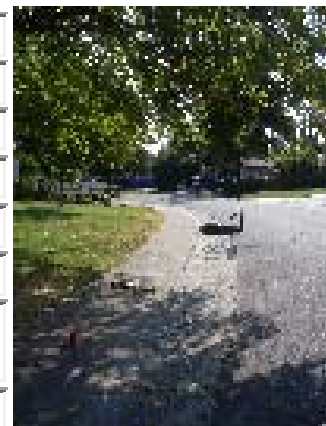
Barrier Type: Cross Slope - Existing (5.0% or more)

Code Ref: CBC 1133B.7.1.3 and ADA/ABA 403.3

As Built Meas: 840 Quantity: LF

Description: Cross slope exceeds 2.0% (5.0% or more)

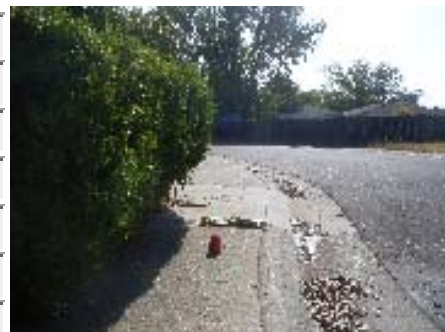
Barrier Type: Clear Width - Existing ($\leq 31"$ or less)

Code Ref: CBC 1133B.7.1

As Built Meas: 1 Quantity: LF

Description: Pedestrian route is not min. 48" wide ($\leq 31"$ or less)

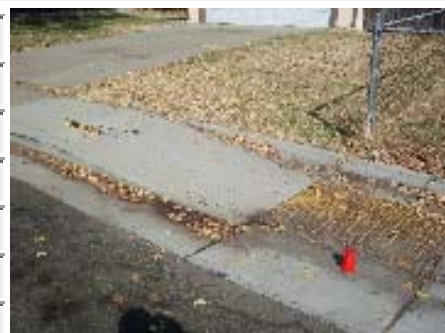
Barrier Type: 12" Grooves - Existing (2.1% to 3.0%)

Code Ref: CBC 1127B.5.6

As Built Meas: 1 Quantity: EACH

Description: 12" grooves at top of curb ramp are not level (2.1% to 3.0%)

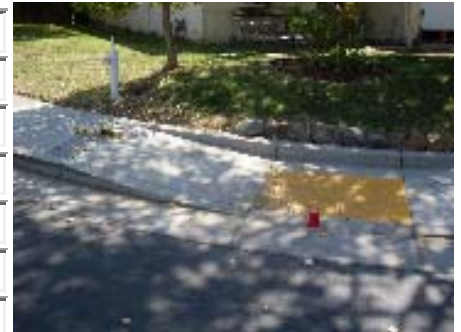
Barrier Type: 12" Grooves - New Construction

Code Ref: CBC 1127B.5.6

As Built Meas: 1 Quantity: EACH

Description: 12" grooves at top of curb ramp are not level (2.1% to 3.0%)

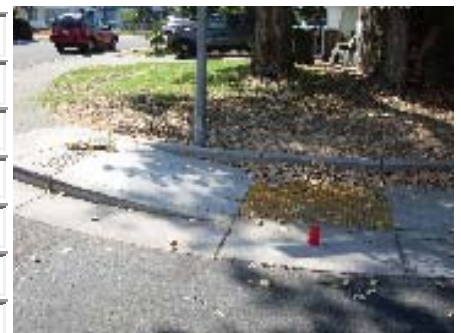
Barrier Type: 12" Grooves - New Construction

Code Ref: CBC 1127B.5.6

As Built Meas: 1 Quantity: EACH

Description: 12" grooves at top of curb ramp are not level (3.1% to 4.0%)

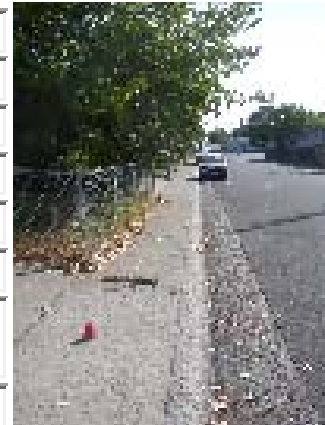
Field Date:	10/7/2010	Report Date:	10/7/2010	Barrier #:	341A
Location:	Viscount Wy - North				
X Coordinate:	-121.31183				
Y Coordinate:	38.71648				
Barrier Area:	Sidewalks				
Barrier Type:	Cross Slope - Existing (5.0% or more)				
Code Ref:	CBC 1133B.7.1.3 and ADA/ABA 403.3

As Built Meas:	338	Quantity:	LF
Description:	Cross slope exceeds 2.0% (5.0% or more)		
As Built Desc:	8.0% cross slope		
Solution:	Demolish existing and construct new route		
Bar. Severity:	1 Necessary	Cost Estimate:	\$42,250.00
Implementation Priority:	4	Facility Function:	
Implementation Phase:		Implementation Date:	
Official Responsible:			
Notes:

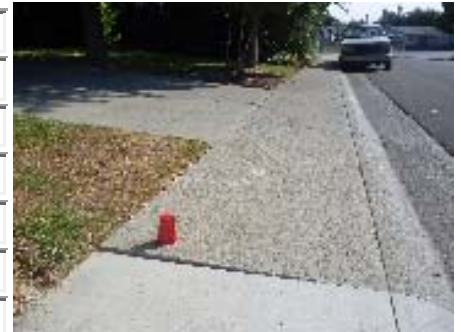
Barrier Type: Abrupt Change in Level - > 1/2"

Code Ref: CBC 1133B.7.1 and ADA/ABA 303.3

As Built Meas: 4 Quantity: LF

Description: Change in level greater than 1/2"

Solution: Grind or repair sidewalk to remove trip hazard

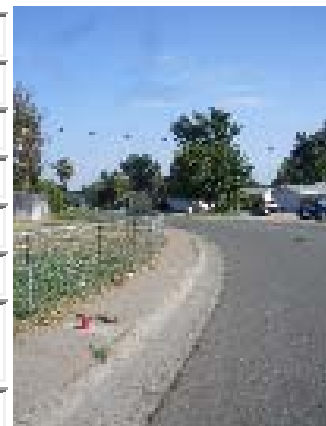
Barrier Type: Cross Slope - Existing (5.0% or more)

Code Ref: CBC 1133B.7.1.3 and ADA/ABA 403.3

As Built Meas: 290 Quantity: LF

Description: Cross slope exceeds 2.0% (5.0% or more)

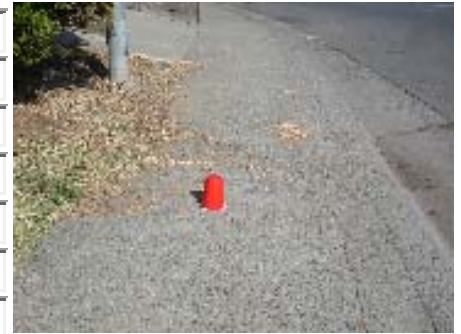
Barrier Type: Surface Condition - Damaged

Code Ref: CBC 1133B.7.1 and ADA/ABA 302.1

As Built Meas: 8 Quantity: LF

Description: Surface is not firm and stable (cracked, broken or loose soil, etc.)

As Built Desc: Cracked concrete

Solution: Repair surface to make firm and stable

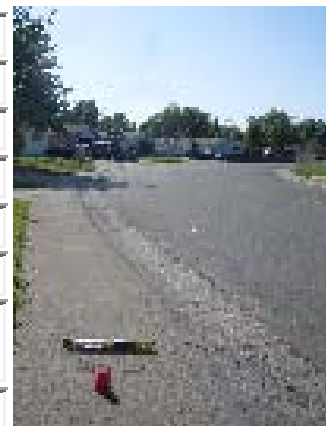
Barrier Type: Cross Slope - Existing (5.0% or more)

Code Ref: CBC 1133B.7.1.3 and ADA/ABA 403.3

As Built Meas: 355 Quantity: LF

Description: Cross slope exceeds 2.0% (5.0% or more)

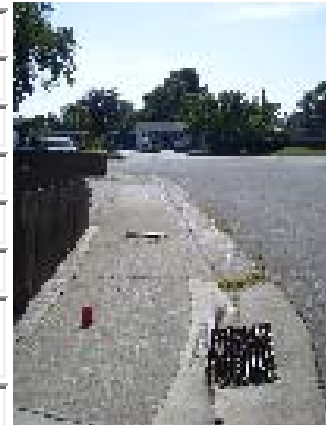
Field Date:	10/7/2010	Report Date:	10/7/2010	Barrier #:	344
Location:	Starling Ct - North				
X Coordinate:	-121.31048				
Y Coordinate:	38.71608				
Barrier Area:	Sidewalks				
Barrier Type:	Cross Slope - Existing (5.0% or more)				
Code Ref:	CBC 1133B.7.1.3 and ADA/ABA 403.3				
As Built Meas:	185	Quantity:	LF		
Description:	Cross slope exceeds 2.0% (5.0% or more)				
As Built Desc:	8.6% cross slope				
Solution:	Demolish existing and construct new route				
Bar. Severity:	1 Necessary	Cost Estimate:	\$23,125.00	Status:	
Implementation Priority:	4	Facility Function:			
Implementation Phase:		Implementation Date:			
Official Responsible:					
Notes:

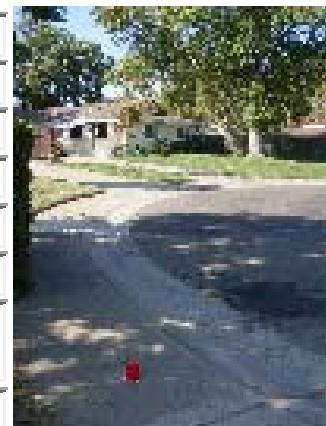
Field Date:	10/7/2010	Report Date:	10/7/2010	Barrier #:	345
Location:	Starling Ct - South				
X Coordinate:	-121.31020				
Y Coordinate:	38.71570				
Barrier Area:	Sidewalks				
Barrier Type:	Cross Slope - Existing (5.0% or more)				
Code Ref:	CBC 1133B.7.1.3 and ADA/ABA 403.3				
As Built Meas:	200	Quantity:	LF		
Description:	Cross slope exceeds 2.0% (5.0% or more)				
As Built Desc:	5.3% cross slope				
Solution:	Demolish existing and construct new route				
Bar. Severity:	1 Necessary	Cost Estimate:	\$25,000.00	Status:	
Implementation Priority:	4	Facility Function:			
Implementation Phase:		Implementation Date:			
Official Responsible:					
Notes:

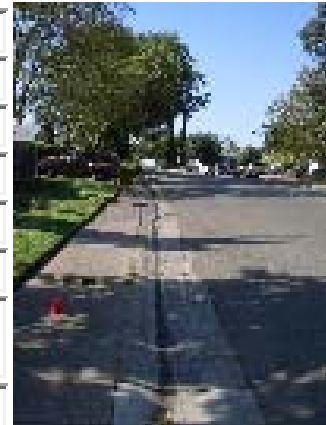
Field Date: 10/7/2010 Report Date: 10/7/2010 Barrier #: 346A

Barrier Type: Cross Slope - Existing (5.0% or more)

Code Ref: CBC 1133B.7.1.3 and ADA/ABA 403.3

As Built Meas: 406 Quantity: LF

Description: Cross slope exceeds 2.0% (5.0% or more)

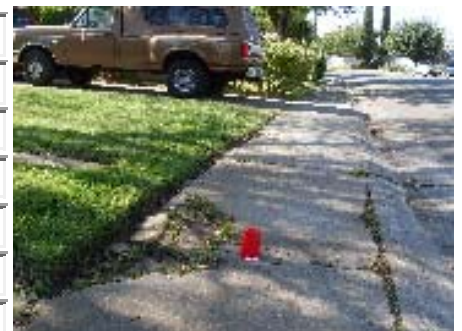
Barrier Type: Surface Condition - Damaged

Code Ref: CBC 1133B.7.1 and ADA/ABA 302.1

As Built Meas: 4 Quantity: LF

Description: Surface is not firm and stable (cracked, broken or loose soil, etc.)

As Built Desc: Cracked concrete

Solution: Repair surface to make firm and stable

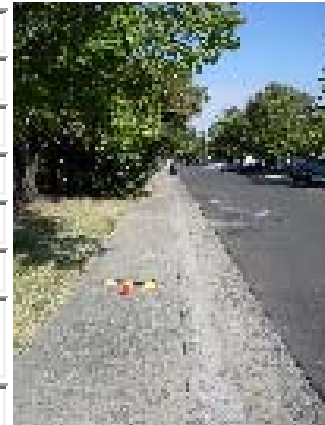
Barrier Type: Cross Slope - Existing (5.0% or more)

Code Ref: CBC 1133B.7.1.3 and ADA/ABA 403.3

As Built Meas: 556 Quantity: LF

Description: Cross slope exceeds 2.0% (5.0% or more)

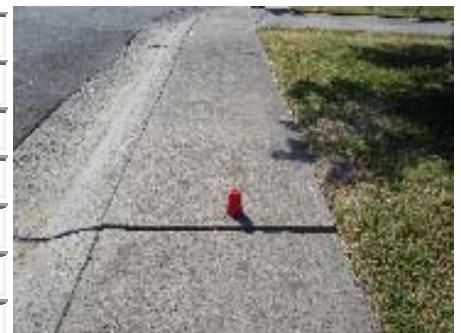
Barrier Type: Abrupt Change in Level - > 1/2"

Code Ref: CBC 1133B.7.1 and ADA/ABA 303.3

As Built Meas: 4 Quantity: LF

Description: Change in level greater than 1/2"

Solution: Grind or repair sidewalk to remove trip hazard

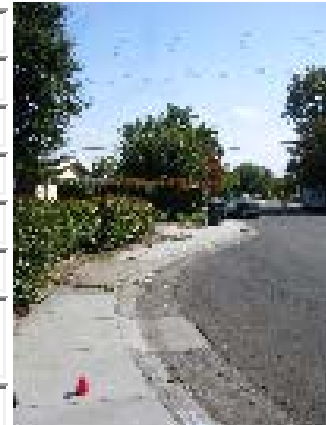
Barrier Type: Cross Slope - Existing (5.0% or more)

Code Ref: CBC 1133B.7.1.3 and ADA/ABA 403.3

As Built Meas: 750 Quantity: LF

Description: Cross slope exceeds 2.0% (5.0% or more)

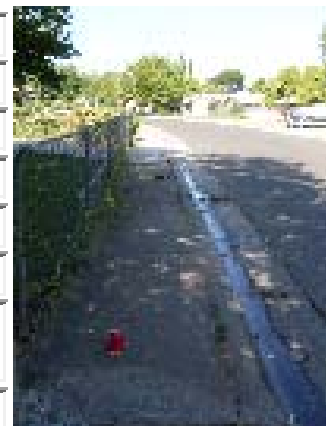
Barrier Type: Cross Slope - Existing (5.0% or more)

Code Ref: CBC 1133B.7.1.3 and ADA/ABA 403.3

As Built Meas: 665 Quantity: LF

Description: Cross slope exceeds 2.0% (5.0% or more)
