DRAFT ADA TRANSITION PLAN UPDATE
NEIGHBORHOOD AREA 1 NORTHWEST
SEPTEMBER 20, 2011

CITY OF CITRUS HEIGHTS

The Northwest Neighborhood Association

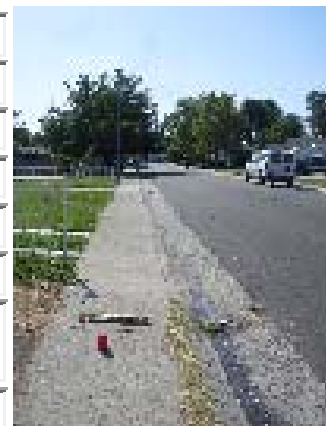
Field Date:	10/7/2010	Report Date:	10/7/2010	Barrier #:	350
Location:	Tanoak Wy - East				
X Coordinate:	-121.30921				
Y Coordinate:	38.71644				
Barrier Area:	Sidewalks				
Barrier Type:	Cross Slope - Existing (5.0% or more)				
Code Ref:	CBC 1133B.7.1.3 and ADA/ABA 403.3

As Built Meas:	456	Quantity:	LF	
Description:	Cross slope exceeds 2.0% (5.0% or more)			
As Built Desc:	5.2% cross slope			
Solution:	Demolish existing and construct new route			
Bar. Severity:	1 Necessary	Cost Estimate:	\$57,000.00	Status:
Implementation Priority:	4	Facility Function:		
Implementation Phase:		Implementation Date:		
Official Responsible:				
Notes:

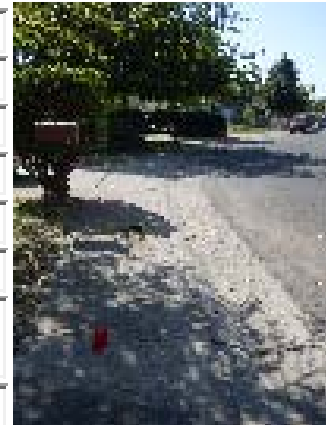
Field Date: 10/7/2010 Report Date: 10/7/2010 Barrier #: 353A

Barrier Type: Cross Slope - Existing (5.0% or more)

Code Ref: CBC 1133B.7.1.3 and ADA/ABA 403.3

As Built Meas: 522 Quantity: LF

Description: Cross slope exceeds 2.0% (5.0% or more)

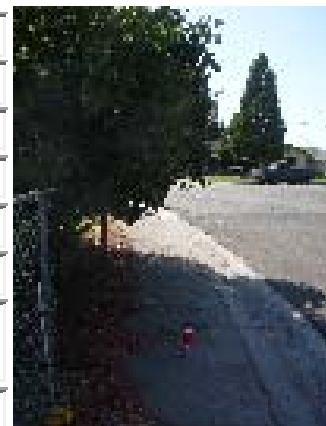
Barrier Type: Protruding Hazard

Code Ref: CBC 1133B.8.6.1 and ADA/ABA 307.2

As Built Meas: 1 Quantity: JOB

Description: Protruding object in route of travel between 27" and 80" high

As Built Desc: 60" protruding hazard at tree branches

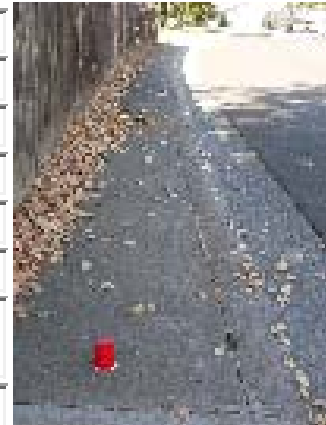
Field Date:	10/7/2010	Report Date:	10/7/2010	Barrier #:	356
Location:	Viscount Wy - East				
X Coordinate:	-121.31192				
Y Coordinate:	38.71643				
Barrier Area:	Sidewalks				
Barrier Type:	Cross Slope - Existing (4.1% to 4.9%)				
Code Ref:	CBC 1133B.7.1.3 and ADA/ABA 403.3

As Built Meas:	166	Quantity:	LF	
Description:	Cross slope exceeds 2.0% (4.1% to 4.9%)			
As Built Desc:	4.8% cross slope			
Solution:	Demolish existing and construct new route			
Bar. Severity:	2 Recommended	Cost Estimate:	\$20,750.00	Status:
Implementation Priority:	4	Facility Function:		
Implementation Phase:		Implementation Date:		
Official Responsible:				
Notes:

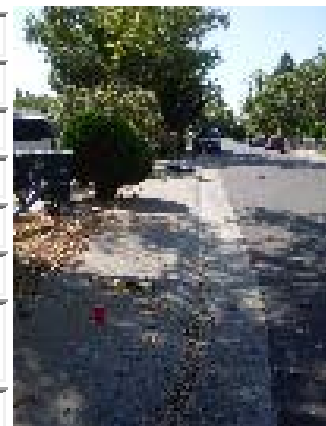
Field Date:	10/7/2010	Report Date:	10/7/2010	Barrier #:	357
Location:	Viscount Wy - South				
X Coordinate:	-121.31245				
Y Coordinate:	38.71657				
Barrier Area:	Sidewalks				
Barrier Type:	Cross Slope - Existing (5.0% or more)				
Code Ref:	CBC 1133B.7.1.3 and ADA/ABA 403.3

As Built Meas:	672	Quantity:	LF	
Description:	Cross slope exceeds 2.0% (5.0% or more)			
As Built Desc:	6.1% cross slope			
Solution:	Demolish existing and construct new route			
Bar. Severity:	1 Necessary	Cost Estimate:	\$84,000.00	Status:
Implementation Priority:	4	Facility Function:		
Implementation Phase:		Implementation Date:		
Official Responsible:				
Notes:

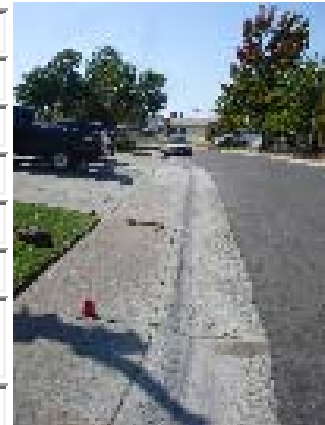
Barrier Type: Cross Slope - Existing (5.0% or more)

Code Ref: CBC 1133B.7.1.3 and ADA/ABA 403.3

As Built Meas: 278 Quantity: LF

Description: Cross slope exceeds 2.0% (5.0% or more)

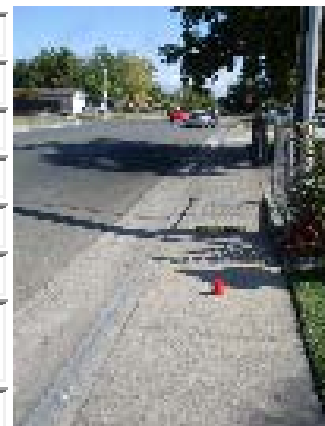
Barrier Type: Cross Slope - Existing (5.0% or more)

Code Ref: CBC 1133B.7.1.3 and ADA/ABA 403.3

As Built Meas: 135 Quantity: LF

Description: Cross slope exceeds 2.0% (5.0% or more)

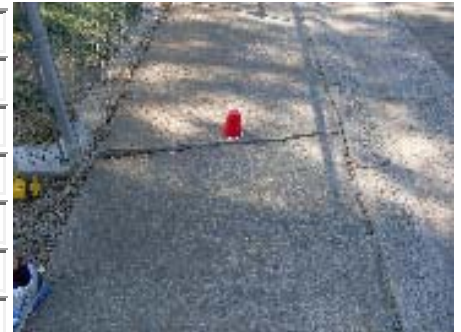
Field Date:	10/7/2010	Report Date:	10/7/2010	Barrier #:	361B
Location:	Outlook Dr - South				
X Coordinate:	-121.31193				
Y Coordinate:	38.71500				
Barrier Area:	Sidewalks				
Barrier Type:	Abrupt Change in Level - > 1/2"				
Code Ref:	CBC 1133B.7.1 and ADA/ABA 303.3

As Built Meas:	4	Quantity:	LF
Description:	Change in level greater than 1/2"		
As Built Desc:	1/2" lip in sidewalk surface		
Solution:	Grind or repair sidewalk to remove trip hazard		
Bar. Severity:	1 Necessary	Cost Estimate:	\$1,000.00
Implementation Priority:	3	Facility Function:	
Implementation Phase:		Implementation Date:	
Official Responsible:			
Notes:

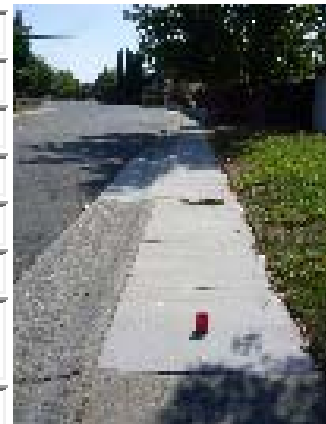
Field Date:	10/7/2010	Report Date:	10/7/2010	Barrier #:	362
Location:	Zenith Dr - West				
X Coordinate:	-121.31162				
Y Coordinate:	38.71496				
Barrier Area:	Sidewalks				
Barrier Type:	Cross Slope - Existing (5.0% or more)				
Code Ref:	CBC 1133B.7.1.3 and ADA/ABA 403.3

As Built Meas:	203	Quantity:	LF
Description:	Cross slope exceeds 2.0% (5.0% or more)		
As Built Desc:	5.7% cross slope		
Solution:	Demolish existing and construct new route		
Bar. Severity:	1 Necessary	Cost Estimate:	\$25,375.00
Implementation Priority:	3	Facility Function:	
Implementation Phase:		Implementation Date:	
Official Responsible:			
Notes:

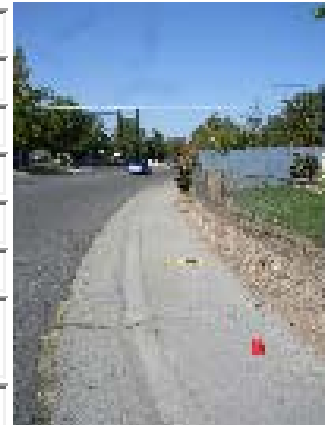
Field Date:	10/7/2010	Report Date:	10/7/2010	Barrier #:	363
Location:	Zenith Dr - East				
X Coordinate:	-121.31140				
Y Coordinate:	38.71439				
Barrier Area:	Sidewalks				
Barrier Type:	Cross Slope - Existing (5.0% or more)				
Code Ref:	CBC 1133B.7.1.3 and ADA/ABA 403.3				
As Built Meas:	216	Quantity:	LF		
Description:	Cross slope exceeds 2.0% (5.0% or more)				
As Built Desc:	6.7% cross slope				
Solution:	Demolish existing and construct new route				
Bar. Severity:	1 Necessary	Cost Estimate:	\$27,000.00	Status:	
Implementation Priority:	3	Facility Function:			
Implementation Phase:		Implementation Date:			
Official Responsible:					
Notes:

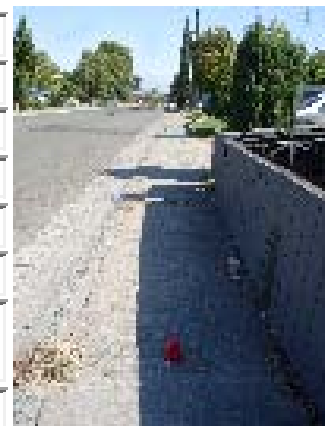
Field Date:	10/7/2010	Report Date:	10/7/2010	Barrier #:	364A
Location:	Outlook Dr- South				
X Coordinate:	-121.31135				
Y Coordinate:	38.71500				
Barrier Area:	Sidewalks				
Barrier Type:	Cross Slope - Existing (5.0% or more)				
Code Ref:	CBC 1133B.7.1.3 and ADA/ABA 403.3				
As Built Meas:	891	Quantity:	LF		
Description:	Cross slope exceeds 2.0% (5.0% or more)				
As Built Desc:	6.5% cross slope				
Solution:	Demolish existing and construct new route				
Bar. Severity:	1 Necessary	Cost Estimate:	\$111,375.00	Status:	
Implementation Priority:	3	Facility Function:			
Implementation Phase:		Implementation Date:			
Official Responsible:					
Notes:

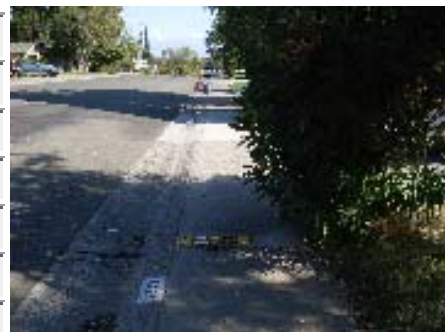
Field Date: 10/7/2010 Report Date: 10/7/2010 Barrier #: 364B

Barrier Type: Clear Width - Existing ($\leq 31"$ or less)

Code Ref: CBC 1133B.7.1

As Built Meas: 1 Quantity: LF

Description: Pedestrian route is not min. 48" wide ($\leq 31"$ or less)

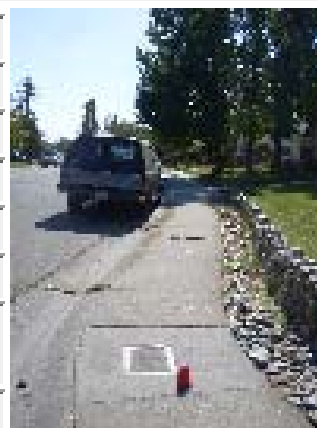
Barrier Type: Cross Slope - Existing (5.0% or more)

Code Ref: CBC 1133B.7.1.3 and ADA/ABA 403.3

As Built Meas: 1188 Quantity: LF

Description: Cross slope exceeds 2.0% (5.0% or more)

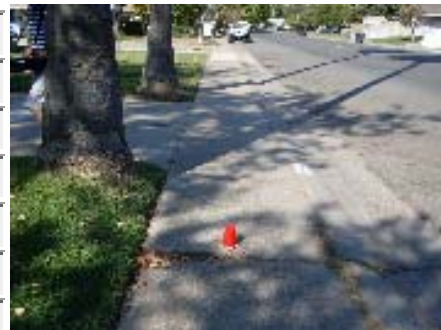
Barrier Type: Abrupt Change in Level - > 1/2"

Code Ref: CBC 1133B.7.1 and ADA/ABA 303.3

As Built Meas: 4 Quantity: LF

Description: Change in level greater than 1/2"

Solution: Grind or repair sidewalk to remove trip hazard

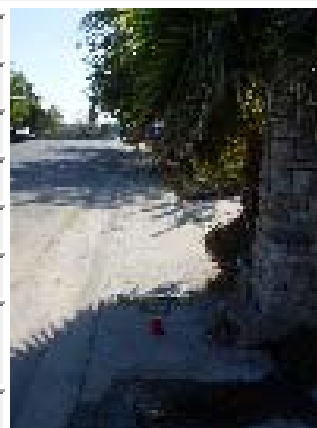
Barrier Type: Protruding Hazard

Code Ref: CBC 1133B.8.6.1 and ADA/ABA 307.2

As Built Meas: 1 Quantity: JOB

Description: Protruding object in route of travel between 27" and 80" high

As Built Desc: 27" protruding hazard at tree branches

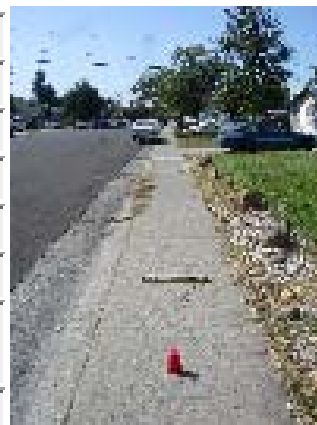
Barrier Type: Cross Slope - Existing (5.0% or more)

Code Ref: CBC 1133B.7.1.3 and ADA/ABA 403.3

As Built Meas: 773 Quantity: LF

Description: Cross slope exceeds 2.0% (5.0% or more)

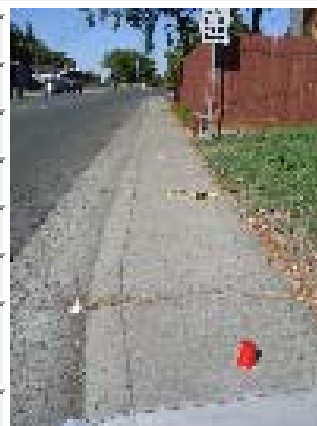
Barrier Type: Cross Slope - Existing (5.0% or more)

Code Ref: CBC 1133B.7.1.3 and ADA/ABA 403.3

As Built Meas: 205 Quantity: LF

Description: Cross slope exceeds 2.0% (5.0% or more)

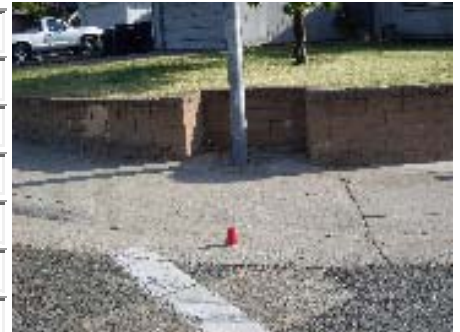
Field Date:	10/8/2010	Report Date:	10/8/2010	Barrier #:	368
Location:	Zenith Dr and Briartree Wy - Corner B				
X Coordinate:	-121.31104				
Y Coordinate:	38.71240				
Barrier Area:	Curb Ramps				
Barrier Type:	No Curb Ramp - Depressed Exsiting Curb				
Code Ref:	CBC 1127B.5.1 and ADA/ABA 402.2

As Built Meas:	1	Quantity:	EACH
Description:	No compliant curb cut at corner (intersection)		
As Built Desc:	13.9% running slope at depressed area		
Solution:	Demolish existing and construct curb cut		
Bar. Severity:	1 Necessary	Cost Estimate:	\$2,500.00
Implementation Priority:	3	Facility Function:	
Implementation Phase:		Implementation Date:	
Official Responsible:			
Notes:	Two - way intersection corners B,C

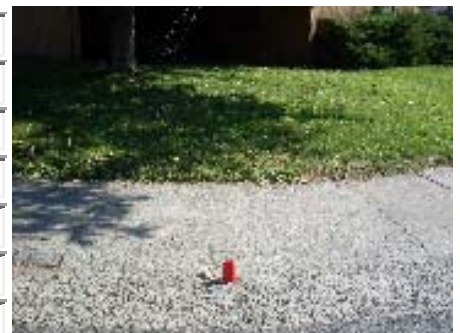
Field Date:	10/7/2010	Report Date:	10/7/2010	Barrier #:	369
Location:	Zenith Dr and Briartree Wy - Corner C				
X Coordinate:	-121.31112				
Y Coordinate:	38.71229				
Barrier Area:	Curb Ramps				
Barrier Type:	No Curb Ramp - Depressed Exsiting Curb				
Code Ref:	CBC 1127B.5.1 and ADA/ABA 402.2

As Built Meas:	1	Quantity:	EACH
Description:	No compliant curb cut at corner (intersection)		
As Built Desc:	11.4% running slope at depressed area		
Solution:	Demolish existing and construct curb cut		
Bar. Severity:	1 Necessary	Cost Estimate:	\$2,500.00
Implementation Priority:	3	Facility Function:	
Implementation Phase:		Implementation Date:	
Official Responsible:			
Notes:	Two - way intersection corners B,C

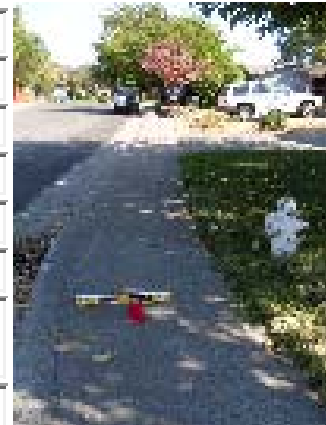
Barrier Type: Cross Slope - Existing (5.0% or more)

As Built Meas: 550 Quantity: LF

Description: Cross slope exceeds 2.0% (5.0% or more)

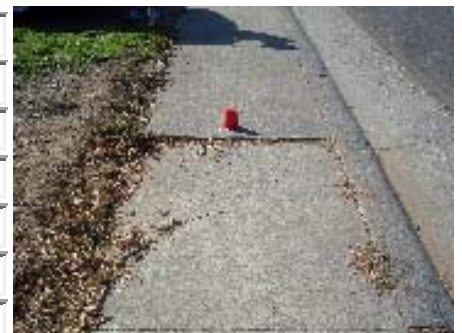
Barrier Type: Abrupt Change in Level - > 1/2"

As Built Meas: 4 Quantity: LF

Description: Change in level greater than 1/2"

Solution: Grind or repair sidewalk to remove trip hazard

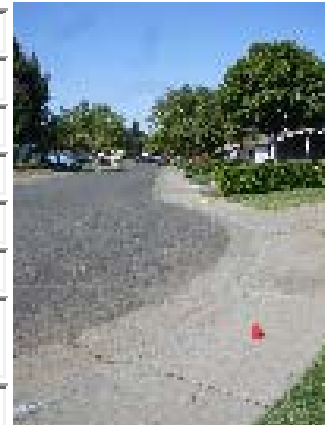
Barrier Type: Cross Slope - Existing (5.0% or more)

As Built Meas: 744 Quantity: LF

Description: Cross slope exceeds 2.0% (5.0% or more)

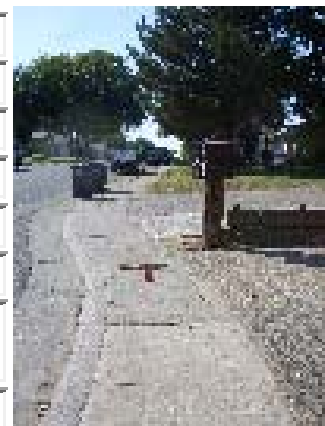
Barrier Type: Cross Slope - Existing (5.0% or more)

As Built Meas: 591 Quantity: LF

Description: Cross slope exceeds 2.0% (5.0% or more)

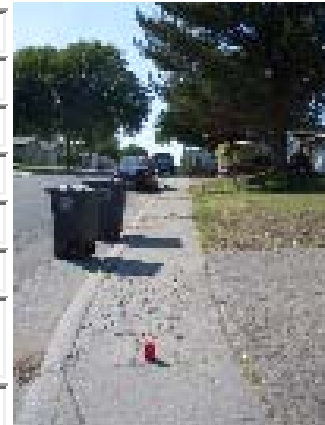
Barrier Type: Surface Condition - Damaged

As Built Meas: 8 Quantity: LF

Description: Surface is not firm and stable (cracked, broken or loose soil, etc.)

As Built Desc: Cracked concrete

Solution: Repair surface to make firm and stable

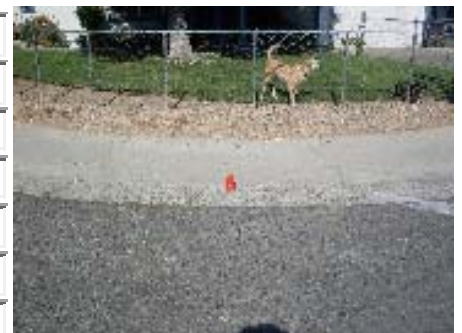
Barrier Type: No Curb Ramp - Depressed Existing Curb

As Built Meas: 1 Quantity: EACH

Description: No compliant curb cut at corner (intersection)

Notes: Four - way intersection corners A,B,C,D. Corners A,D compliant

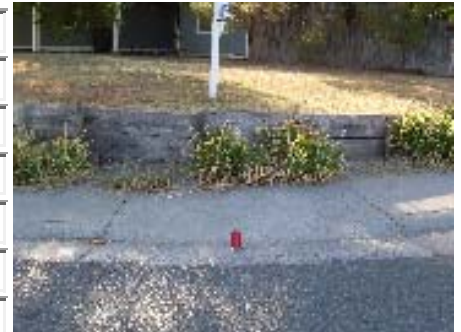
Field Date:	10/8/2010	Report Date:	10/8/2010	Barrier #:	374
Location:	Briartree Wy and Zenith Dr - Corner C				
X Coordinate:	-121.31134				
Y Coordinate:	38.71424				
Barrier Area:	Curb Ramps				
Barrier Type:	No Curb Ramp - Depressed Exsiting Curb				
Code Ref:	CBC 1127B.5.1 and ADA/ABA 402.2

As Built Meas:	1	Quantity:	EACH
Description:	No compliant curb cut at corner (intersection)		
As Built Desc:	12.8% running slope at depressed area		
Solution:	Demolish existing and construct curb cut		
Bar. Severity:	1 Necessary	Cost Estimate:	\$2,500.00
Implementation Priority:	4	Facility Function:	
Implementation Phase:		Implementation Date:	
Official Responsible:			
Notes:	Four - way intersection corners A,B,C,D. Corners A,D compliant

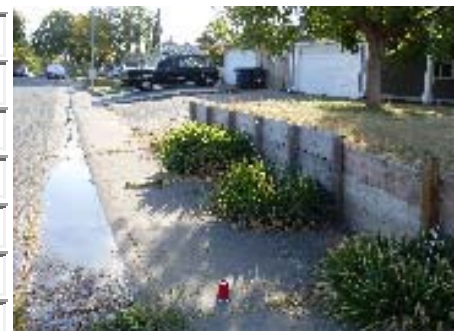
Field Date:	10/8/2010	Report Date:	10/8/2010	Barrier #:	375
Location:	Briartree Wy - South				
X Coordinate:	-121.31115				
Y Coordinate:	38.71426				
Barrier Area:	Sidewalks				
Barrier Type:	Cross Slope - Existing (5.0% or more)				
Code Ref:	CBC 1133B.7.1.3 and ADA/ABA 403.3

As Built Meas:	280	Quantity:	LF
Description:	Cross slope exceeds 2.0% (5.0% or more)		
As Built Desc:	5.0% cross slope		
Solution:	Demolish existing and construct new route		
Bar. Severity:	1 Necessary	Cost Estimate:	\$35,000.00
Implementation Priority:	4	Facility Function:	
Implementation Phase:		Implementation Date:	
Official Responsible:			
Notes:

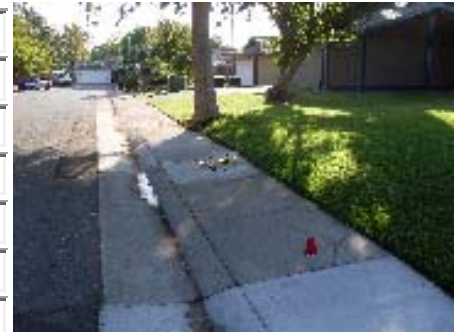
Barrier Type: Cross Slope - Existing (5.0% or more)

As Built Meas: 203 Quantity: LF

Description: Cross slope exceeds 2.0% (5.0% or more)

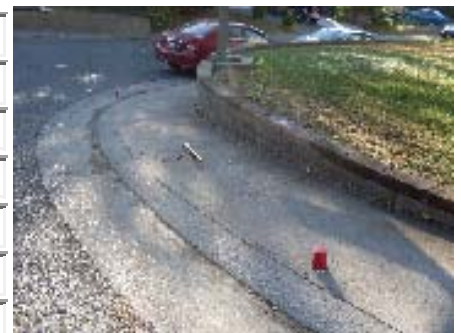
Barrier Type: Running Slope (Existing)

As Built Meas: 20 Quantity: LF

Description: Running slope exceeds 5.0%

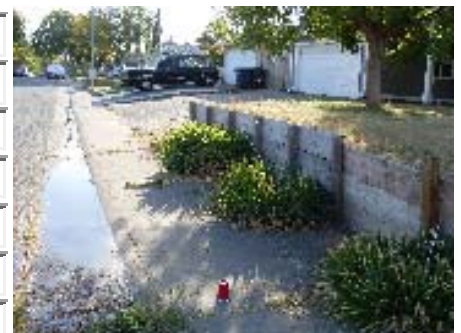
Barrier Type: Cross Slope - Existing (5.0% or more)

As Built Meas: 134 Quantity: LF

Description: Cross slope exceeds 2.0% (5.0% or more)

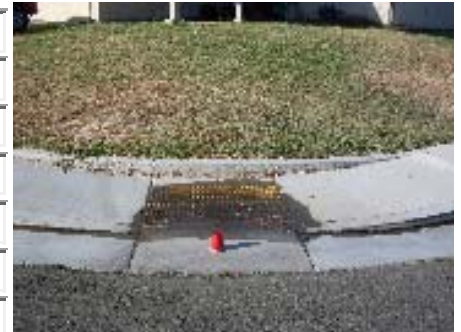
Barrier Type: Water Accumulation - New Construction

As Built Meas: 1 Quantity: EACH

Description: Water does not drain off of curb ramp

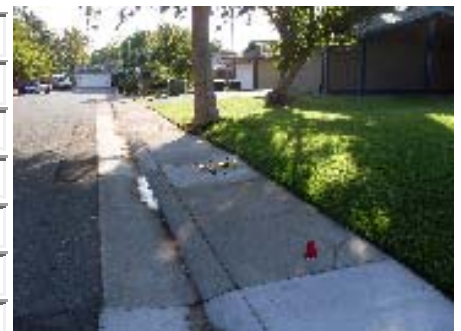
Barrier Type: Cross Slope - Existing (5.0% or more)

As Built Meas: 150 Quantity: LF

Description: Cross slope exceeds 2.0% (5.0% or more)

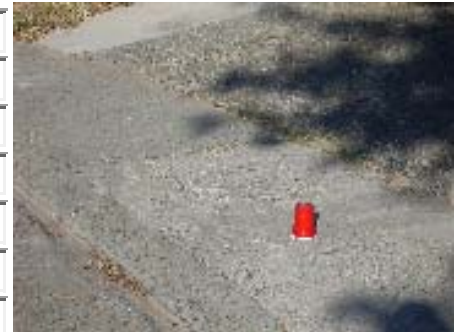
Barrier Type: Surface Condition - Damaged

As Built Meas: 4 Quantity: LF

Description: Surface is not firm and stable (cracked, broken or loose soil, etc.)

As Built Desc: Cracked concrete

Solution: Repair surface to make firm and stable

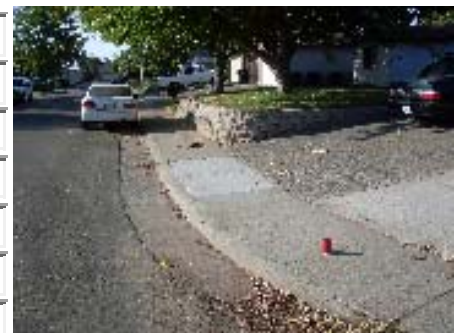
Barrier Type: Cross Slope - Existing (5.0% or more)

As Built Meas: 383 Quantity: LF

Description: Cross slope exceeds 2.0% (5.0% or more)

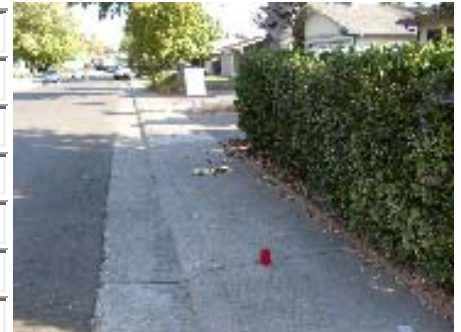
Barrier Type: Cross Slope - Existing (5.0% or more)

As Built Meas: 333 Quantity: LF

Description: Cross slope exceeds 2.0% (5.0% or more)

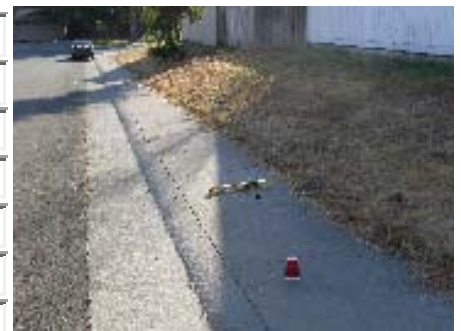
Barrier Type: Cross Slope - Existing (5.0% or more)

As Built Meas: 142 Quantity: LF

Description: Cross slope exceeds 2.0% (5.0% or more)

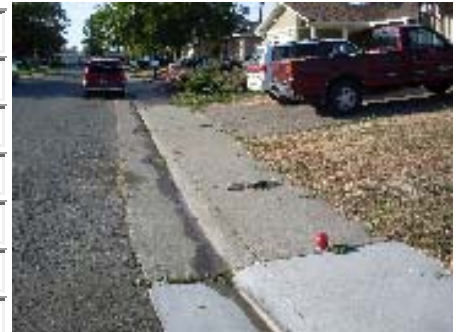
Field Date:	10/8/2010	Report Date:	10/8/2010	Barrier #:	384
Location:	Briartree Wy - West				
X Coordinate:	-121.30939				
Y Coordinate:	38.71356				
Barrier Area:	Sidewalks				
Barrier Type:	Cross Slope - Existing (5.0% or more)				
Code Ref:	CBC 1133B.7.1.3 and ADA/ABA 403.3

As Built Meas:	383	Quantity:	LF
Description:	Cross slope exceeds 2.0% (5.0% or more)		
As Built Desc:	5.4% cross slope		
Solution:	Demolish existing and construct new route		
Bar. Severity:	1 Necessary	Cost Estimate:	\$47,875.00
Implementation Priority:	4	Facility Function:	
Implementation Phase:		Implementation Date:	
Official Responsible:			
Notes:

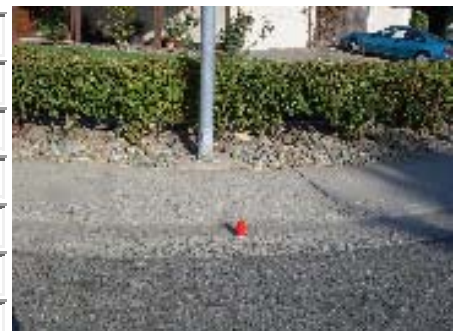
Field Date:	10/8/2010	Report Date:	10/8/2010	Barrier #:	385
Location:	Briartree Wy - West				
X Coordinate:	-121.30936				
Y Coordinate:	38.71240				
Barrier Area:	Sidewalks				
Barrier Type:	Elbow in Sidewalk - Cross Slope (5.0% or more)				
Code Ref:	CBC 1133B.7.1.3 and ADA/ABA 403.3

As Built Meas:	8	Quantity:	LF
Description:	Cross slope at elbow exceeds 2.0% (5.0% or more)		
As Built Desc:	12.0% cross slope		
Solution:	Demolish existing and construct new sidewalk without curb ramp		
Bar. Severity:	1 Necessary	Cost Estimate:	\$1,000.00
Implementation Priority:	4	Facility Function:	
Implementation Phase:		Implementation Date:	
Official Responsible:			
Notes:

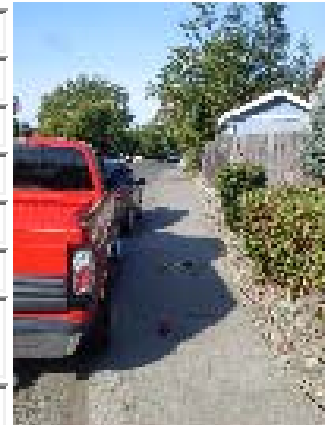
Field Date:	10/8/2010	Report Date:	10/8/2010	Barrier #:	386A
Location:	Briartree Wy - North				
X Coordinate:	-121.30936				
Y Coordinate:	38.71240				
Barrier Area:	Sidewalks				
Barrier Type:	Cross Slope - Existing (5.0% or more)				
Code Ref:	CBC 1133B.7.1.3 and ADA/ABA 403.3

As Built Meas:	166	Quantity:	LF	
Description:	Cross slope exceeds 2.0% (5.0% or more)			
As Built Desc:	6.3% cross slope			
Solution:	Demolish existing and construct new route			
Bar. Severity:	1 Necessary	Cost Estimate:	\$20,750.00	Status:
Implementation Priority:	4	Facility Function:		
Implementation Phase:		Implementation Date:		
Official Responsible:				
Notes:

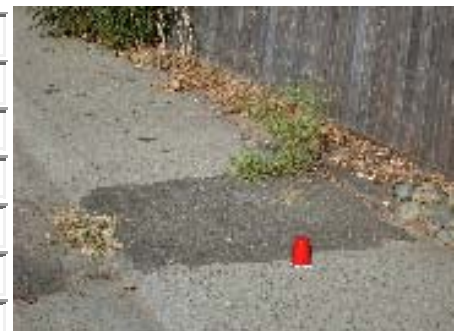
Field Date:	10/8/2010	Report Date:	10/8/2010	Barrier #:	386B
Location:	Briartree Wy - North				
X Coordinate:	-121.30965				
Y Coordinate:	38.71234				
Barrier Area:	Sidewalks				
Barrier Type:	Surface Condition - Damaged				
Code Ref:	CBC 1133B.7.1 and ADA/ABA 302.1

As Built Meas:	4	Quantity:	LF	
Description:	Surface is not firm and stable (cracked, broken or loose soil, etc.)			
As Built Desc:	Cracked concrete			
Solution:	Repair surface to make firm and stable			
Bar. Severity:	1 Necessary	Cost Estimate:	\$500.00	Status:
Implementation Priority:	4	Facility Function:		
Implementation Phase:		Implementation Date:		
Official Responsible:				
Notes:

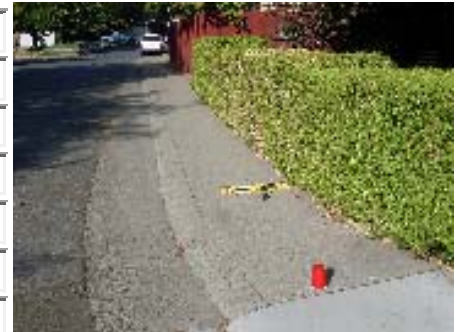
Barrier Type: Cross Slope - Existing (5.0% or more)

As Built Meas: 220 Quantity: LF

Description: Cross slope exceeds 2.0% (5.0% or more)

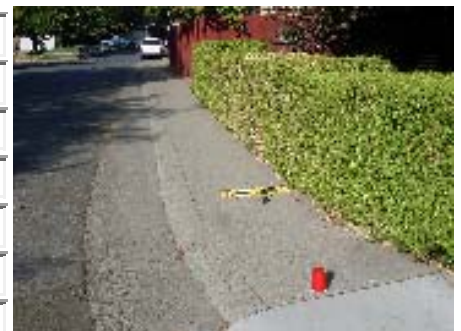
Barrier Type: Clear Width - Existing (36" to 43")

As Built Meas: 1 Quantity: LF

Description: Pedestrian route is not min. 48" wide (36" to 43")

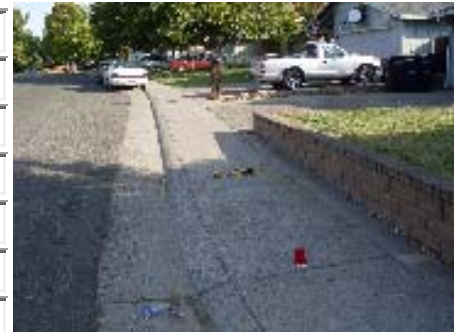
Barrier Type: Cross Slope - Existing (5.0% or more)

As Built Meas: 622 Quantity: LF

Description: Cross slope exceeds 2.0% (5.0% or more)

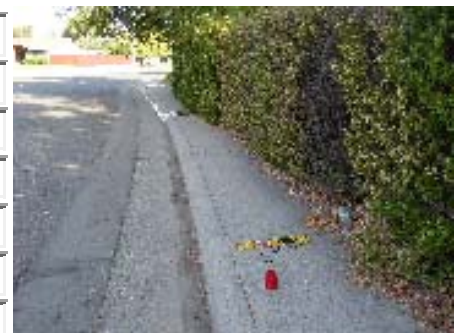
Barrier Type: Clear Width - Existing ($\leq 31"$ or less)

As Built Meas: 1 Quantity: LF

Description: Pedestrian route is not min. 48" wide ($\leq 31"$ or less)

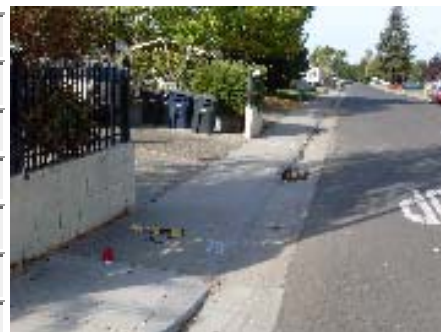
Barrier Type: Cross Slope - Existing (5.0% or more)

As Built Meas: 177 Quantity: LF

Description: Cross slope exceeds 2.0% (5.0% or more)

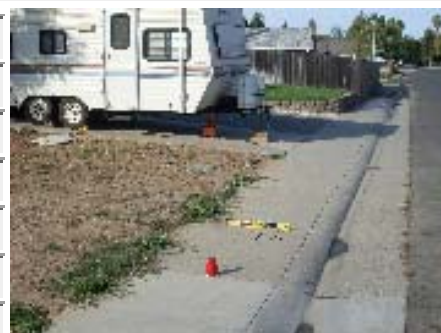
Barrier Type: Cross Slope - Existing (5.0% or more)

As Built Meas: 182 Quantity: LF

Description: Cross slope exceeds 2.0% (5.0% or more)

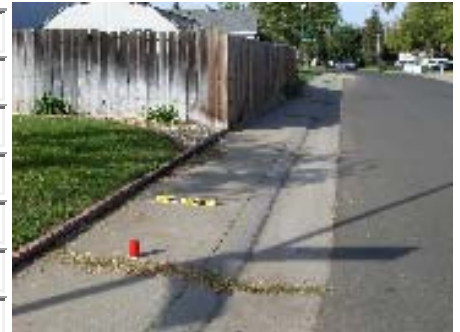
Field Date:	10/8/2010	Report Date:	10/8/2010	Barrier #:	391
Location:	Briartree Wy - South				
X Coordinate:	-121.31319				
Y Coordinate:	38.71419				
Barrier Area:	Sidewalks				
Barrier Type:	Cross Slope - Existing (4.1% to 4.9%)				
Code Ref:	CBC 1133B.7.1.3 and ADA/ABA 403.3

As Built Meas:	186	Quantity:	LF	
Description:	Cross slope exceeds 2.0% (4.1% to 4.9%)			
As Built Desc:	4.5% cross slope			
Solution:	Demolish existing and construct new route			
Bar. Severity:	2 Recommended	Cost Estimate:	\$23,250.00	Status:
Implementation Priority:	4	Facility Function:		
Implementation Phase:		Implementation Date:		
Official Responsible:

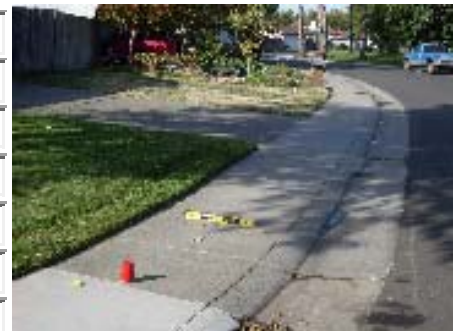
Field Date:	10/8/2010	Report Date:	10/8/2010	Barrier #:	392
Location:	Briartree Wy - South				
X Coordinate:	-121.31412				
Y Coordinate:	38.71418				
Barrier Area:	Sidewalks				
Barrier Type:	Cross Slope - Existing (5.0% or more)				
Code Ref:	CBC 1133B.7.1.3 and ADA/ABA 403.3

As Built Meas:	220	Quantity:	LF	
Description:	Cross slope exceeds 2.0% (5.0% or more)			
As Built Desc:	5.3% cross slope			
Solution:	Demolish existing and construct new route			
Bar. Severity:	1 Necessary	Cost Estimate:	\$27,500.00	Status:
Implementation Priority:	4	Facility Function:		
Implementation Phase:		Implementation Date:		
Official Responsible:

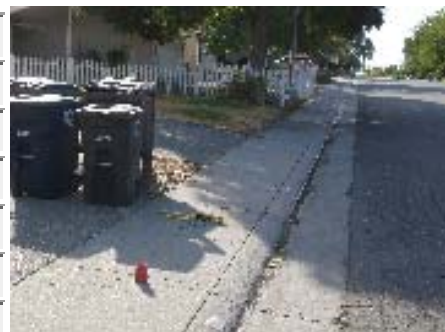
Barrier Type: Cross Slope - Existing (5.0% or more)

As Built Meas: 582 Quantity: LF

Description: Cross slope exceeds 2.0% (5.0% or more)

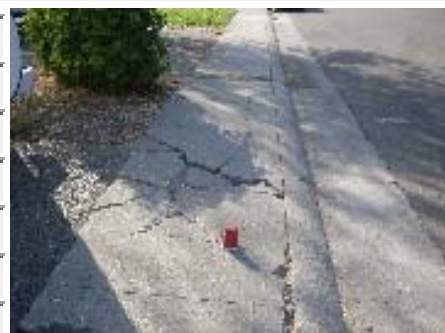
Barrier Type: Surface Condition - Damaged

As Built Meas: 12 Quantity: LF

Description: Surface is not firm and stable (cracked, broken or loose soil, etc.)

As Built Desc: Cracked concrete

Solution: Repair surface to make firm and stable

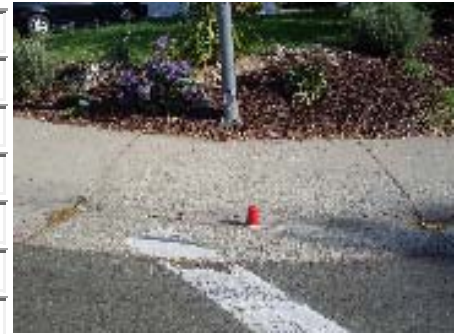
Barrier Type: No Curb Ramp - Depressed Exsiting Curb

As Built Meas: 1 Quantity: EACH

Description: No compliant curb cut at corner (intersection)

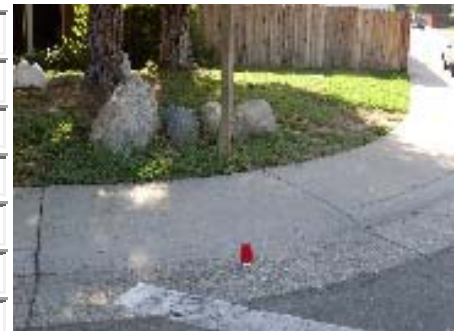
Barrier Type: No Curb Ramp - Depressed Exsiting Curb

As Built Meas: 1 Quantity: EACH

Description: No compliant curb cut at corner (intersection)

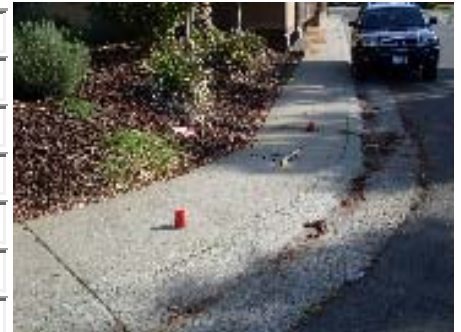
Barrier Type: Running Slope (Existing)

As Built Meas: 14 Quantity: LF

Description: Running slope exceeds 5.0%

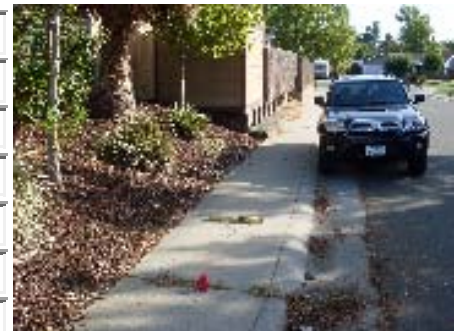
Barrier Type: Cross Slope - Existing (5.0% or more)

As Built Meas: 198 Quantity: LF

Description: Cross slope exceeds 2.0% (5.0% or more)

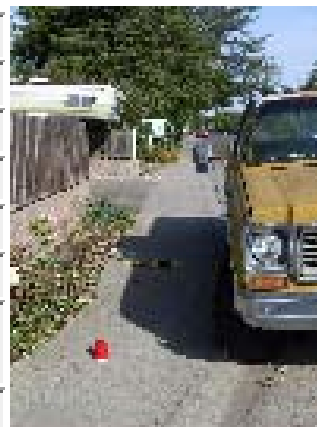
Barrier Type: Cross Slope - Existing (5.0% or more)

As Built Meas: 712 Quantity: LF

Description: Cross slope exceeds 2.0% (5.0% or more)

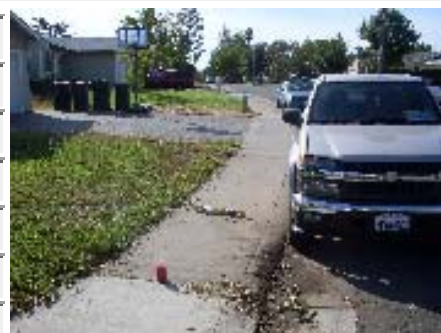
Barrier Type: Cross Slope - Existing (5.0% or more)

As Built Meas: 730 Quantity: LF

Description: Cross slope exceeds 2.0% (5.0% or more)

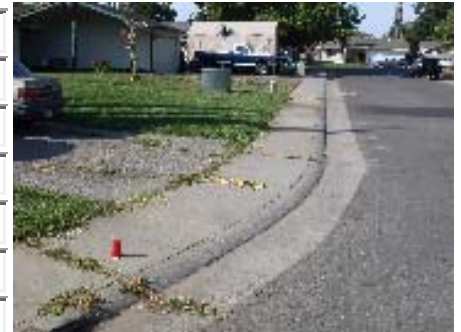
Barrier Type: Cross Slope - Existing (5.0% or more)

As Built Meas: 187 Quantity: LF

Description: Cross slope exceeds 2.0% (5.0% or more)

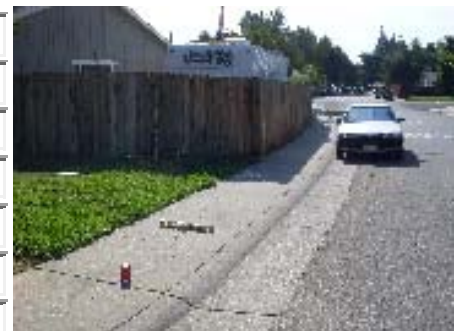
Barrier Type: Cross Slope - Existing (5.0% or more)

As Built Meas: 186 Quantity: LF

Description: Cross slope exceeds 2.0% (5.0% or more)

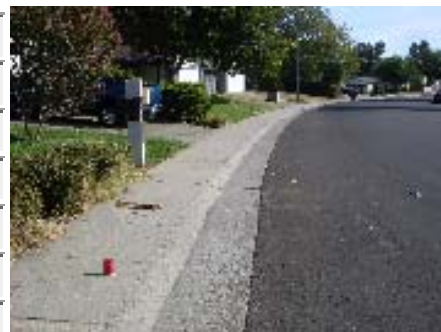
Barrier Type: Cross Slope - Existing (5.0% or more)

Code Ref: CBC 1133B.7.1.3 and ADA/ABA 403.3

As Built Meas: 306 Quantity: LF

Description: Cross slope exceeds 2.0% (5.0% or more)

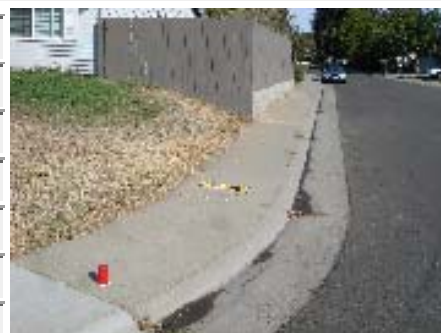
Barrier Type: Cross Slope - Existing (5.0% or more)

Code Ref: CBC 1133B.7.1.3 and ADA/ABA 403.3

As Built Meas: 950 Quantity: LF

Description: Cross slope exceeds 2.0% (5.0% or more)

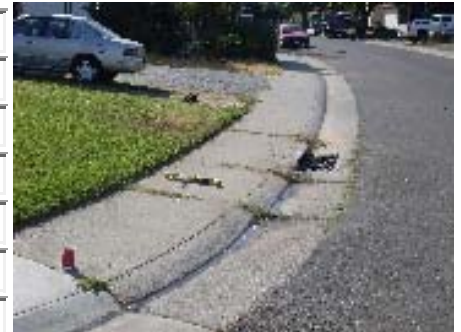
Barrier Type: Cross Slope - Existing (5.0% or more)

Code Ref: CBC 1133B.7.1.3 and ADA/ABA 403.3

As Built Meas: 266 Quantity: LF

Description: Cross slope exceeds 2.0% (5.0% or more)

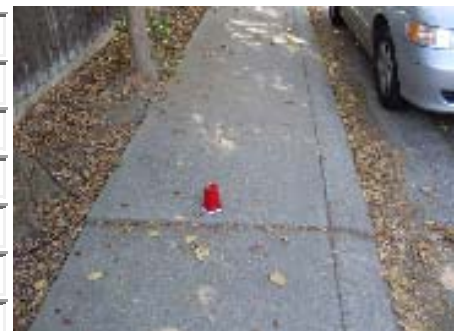
Barrier Type: Abrupt Change in Level - > 1/2"

Code Ref: CBC 1133B.7.1 and ADA/ABA 303.3

As Built Meas: 4 Quantity: LF

Description: Change in level greater than 1/2"

Solution: Grind or repair sidewalk to remove trip hazard

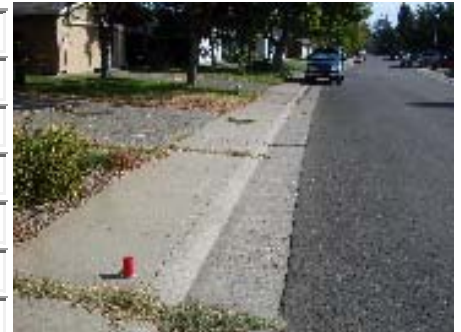
Barrier Type: Cross Slope - Existing (4.1% to 4.9%)

Code Ref: CBC 1133B.7.1.3 and ADA/ABA 403.3

As Built Meas: 383 Quantity: LF

Description: Cross slope exceeds 2.0% (4.1% to 4.9%)

Bar. Severity: 2 Recommended

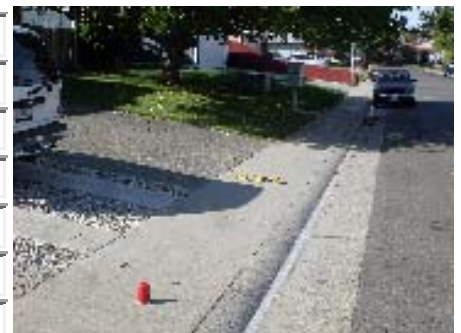
Barrier Type: Cross Slope - Existing (5.0% or more)

Code Ref: CBC 1133B.7.1.3 and ADA/ABA 403.3

As Built Meas: 324 Quantity: LF

Description: Cross slope exceeds 2.0% (5.0% or more)

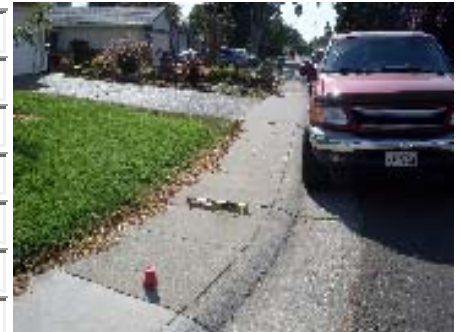
Barrier Type: Cross Slope - Existing (5.0% or more)

Code Ref: CBC 1133B.7.1.3 and ADA/ABA 403.3

As Built Meas: 182 Quantity: LF

Description: Cross slope exceeds 2.0% (5.0% or more)

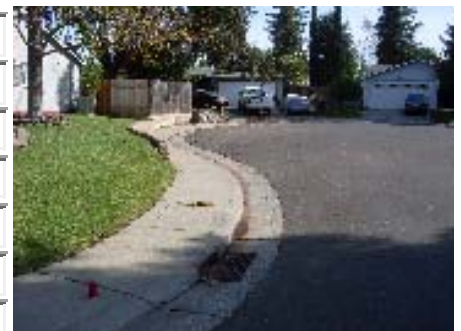
Barrier Type: Cross Slope - Existing (4.1% to 4.9%)

Code Ref: CBC 1133B.7.1.3 and ADA/ABA 403.3

As Built Meas: 122 Quantity: LF

Description: Cross slope exceeds 2.0% (4.1% to 4.9%)

Bar. Severity: 2 Recommended Cost Estimate: \$15,250.00 Status:

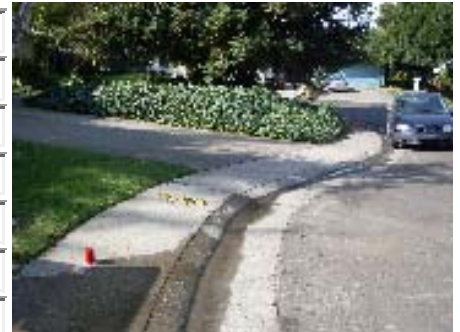
Field Date:	10/8/2010	Report Date:	10/8/2010	Barrier #:	408
Location:	Grey Oak Ct - South				
X Coordinate:	-121.31203				
Y Coordinate:	38.71275				
Barrier Area:	Sidewalks				
Barrier Type:	Cross Slope - Existing (5.0% or more)				
Code Ref:	CBC 1133B.7.1.3 and ADA/ABA 403.3

As Built Meas:	69	Quantity:	LF
Description:	Cross slope exceeds 2.0% (5.0% or more)		
As Built Desc:	6.2% cross slope		
Solution:	Demolish existing and construct new route		
Bar. Severity:	1 Necessary	Cost Estimate:	\$8,625.00
Implementation Priority:	4	Facility Function:	
Implementation Phase:		Implementation Date:	
Official Responsible:			
Notes:

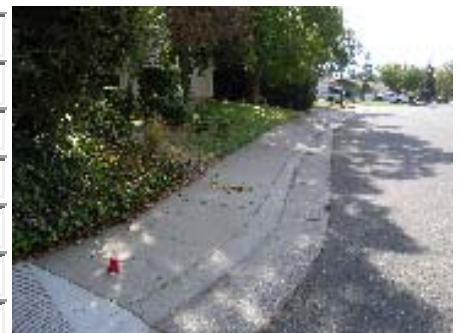
Field Date:	10/8/2010	Report Date:	10/8/2010	Barrier #:	409
Location:	Cornerstone Wy - East				
X Coordinate:	-121.31231				
Y Coordinate:	38.71272				
Barrier Area:	Sidewalks				
Barrier Type:	Cross Slope - Existing (5.0% or more)				
Code Ref:	CBC 1133B.7.1.3 and ADA/ABA 403.3

As Built Meas:	353	Quantity:	LF
Description:	Cross slope exceeds 2.0% (5.0% or more)		
As Built Desc:	5.3% cross slope		
Solution:	Demolish existing and construct new route		
Bar. Severity:	1 Necessary	Cost Estimate:	\$44,125.00
Implementation Priority:	4	Facility Function:	
Implementation Phase:		Implementation Date:	
Official Responsible:			
Notes:

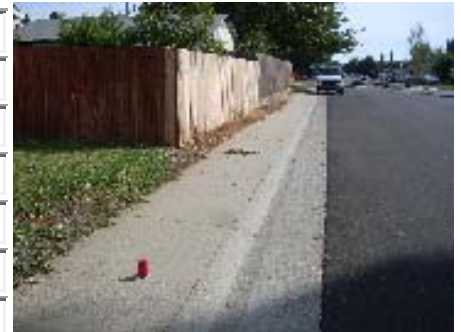
Barrier Type: Cross Slope - Existing (5.0% or more)

Code Ref: CBC 1133B.7.1.3 and ADA/ABA 403.3

As Built Meas: 140 Quantity: LF

Description: Cross slope exceeds 2.0% (5.0% or more)

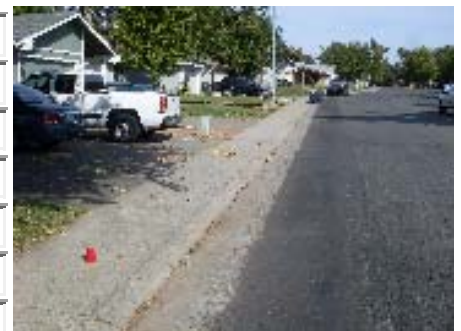
Barrier Type: Cross Slope - Existing (5.0% or more)

Code Ref: CBC 1133B.7.1.3 and ADA/ABA 403.3

As Built Meas: 659 Quantity: LF

Description: Cross slope exceeds 2.0% (5.0% or more)

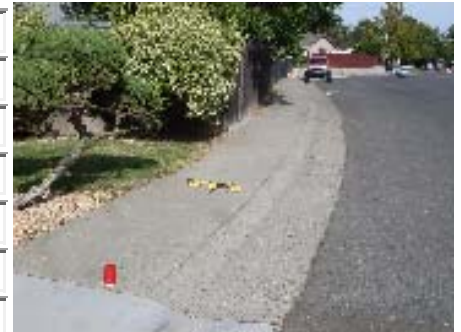
Barrier Type: Cross Slope - Existing (4.1% to 4.9%)

Code Ref: CBC 1133B.7.1.3 and ADA/ABA 403.3

As Built Meas: 171 Quantity: LF

Description: Cross slope exceeds 2.0% (4.1% to 4.9%)

Bar. Severity: 2 Recommended Cost Estimate: \$21,375.00 Status:

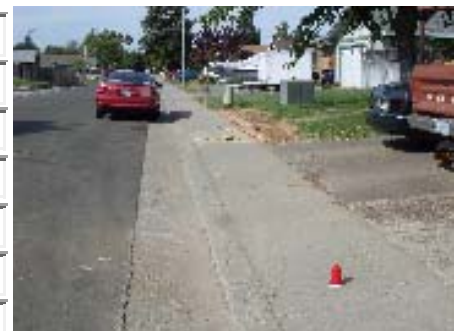
Barrier Type: Cross Slope - Existing (5.0% or more)

Code Ref: CBC 1133B.7.1.3 and ADA/ABA 403.3

As Built Meas: 1041 Quantity: LF

Description: Cross slope exceeds 2.0% (5.0% or more)

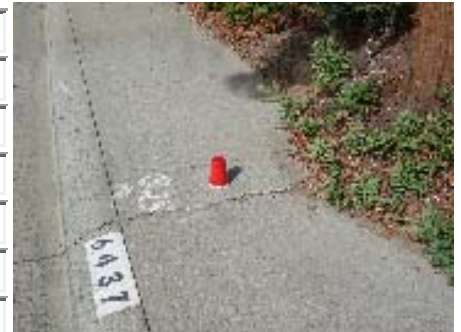
Field Date:	10/8/2010	Report Date:	10/8/2010	Barrier #:	413B
Location:	Briartree Wy - North				
X Coordinate:	-121.31311				
Y Coordinate:	38.71432				
Barrier Area:	Sidewalks				
Barrier Type:	Abrupt Change in Level - Tree Heaves				
Code Ref:	CBC 1133B.7.1 and ADA/ABA 303.3

As Built Meas:	12	Quantity:	LF
Description:	Change in level greater than 1/2"		
As Built Desc:	1" lip due to tree heaves		
Solution:	Grind or repair sidewalk to remove trip hazard		
Bar. Severity:	1 Necessary	Cost Estimate:	\$3,000.00
Implementation Priority:	4	Facility Function:	
Implementation Phase:		Implementation Date:	
Official Responsible:			
Notes:

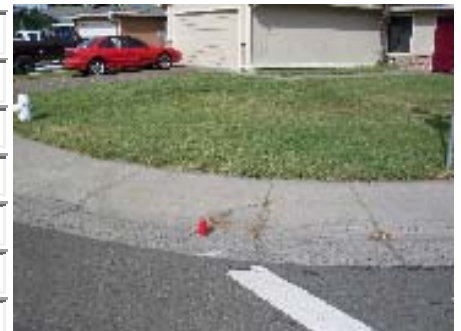
Field Date:	10/8/2010	Report Date:	10/8/2010	Barrier #:	414
Location:	Summerplace Dr and Villaview Dr - Corner A				
X Coordinate:	-121.31596				
Y Coordinate:	38.71434				
Barrier Area:	Curb Ramps				
Barrier Type:	No Curb Ramp - Depressed Exsiting Curb				
Code Ref:	CBC 1127B.5.1 and ADA/ABA 402.2

As Built Meas:	1	Quantity:	EACH
Description:	No compliant curb cut at corner (intersection)		
As Built Desc:	16.4% running slope at depressed area		
Solution:	Demolish existing and construct curb cut		
Bar. Severity:	1 Necessary	Cost Estimate:	\$2,500.00
Implementation Priority:	4	Facility Function:	
Implementation Phase:		Implementation Date:	
Official Responsible:			
Notes:	Two - way intersection corners A,B

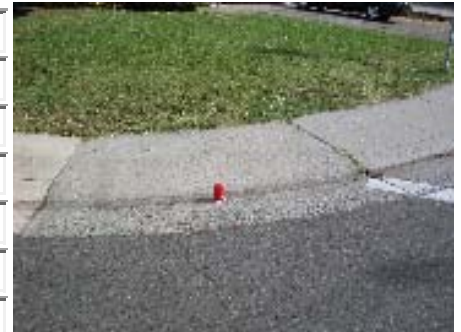
Barrier Type: No Curb Ramp - Depressed Exsiting Curb

Code Ref: CBC 1127B.5.1 and ADA/ABA 402.2

As Built Meas: 1 Quantity: EACH

Description: No compliant curb cut at corner (intersection)

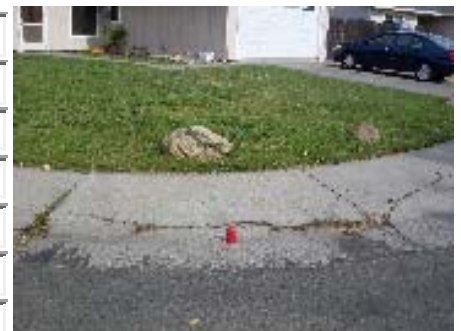
Barrier Type: No Curb Ramp - Depressed Exsiting Curb

Code Ref: CBC 1127B.5.1 and ADA/ABA 402.2

As Built Meas: 1 Quantity: EACH

Description: No compliant curb cut at corner (intersection)

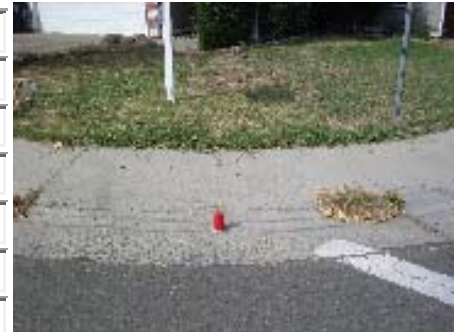
Field Date:	10/8/2010	Report Date:	10/8/2010	Barrier #:	417
Location:	Summerplace Dr and Paco Ct - Corner D				
X Coordinate:	-121.31696				
Y Coordinate:	38.71402				
Barrier Area:	Curb Ramps				
Barrier Type:	No Curb Ramp - Depressed Exsiting Curb				
Code Ref:	CBC 1127B.5.1 and ADA/ABA 402.2

As Built Meas:	1	Quantity:	EACH
Description:	No compliant curb cut at corner (intersection)		
As Built Desc:	13.7% running slope at depressed area		
Solution:	Demolish existing and construct curb cut		
Bar. Severity:	1 Necessary	Cost Estimate:	\$2,500.00
Implementation Priority:	4	Facility Function:	
Implementation Phase:		Implementation Date:	
Official Responsible:			
Notes:	Two - way intersection corners A,D

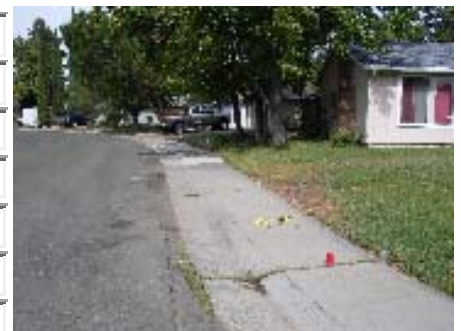
Field Date:	10/8/2010	Report Date:	10/8/2010	Barrier #:	418
Location:	Paco Ct - North				
X Coordinate:	-121.31677				
Y Coordinate:	38.71410				
Barrier Area:	Sidewalks				
Barrier Type:	Cross Slope - Existing (5.0% or more)				
Code Ref:	CBC 1133B.7.1.3 and ADA/ABA 403.3

As Built Meas:	315	Quantity:	LF
Description:	Cross slope exceeds 2.0% (5.0% or more)		
As Built Desc:	6.0% cross slope		
Solution:	Demolish existing and construct new route		
Bar. Severity:	1 Necessary	Cost Estimate:	\$39,375.00
Implementation Priority:	4	Facility Function:	
Implementation Phase:		Implementation Date:	
Official Responsible:			
Notes:

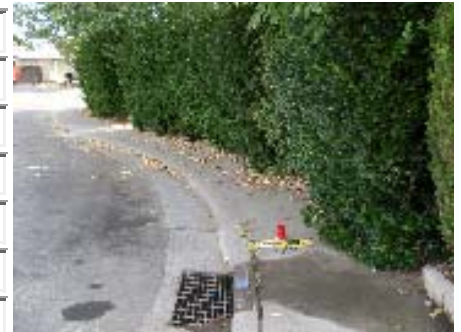
Field Date:	10/8/2010	Report Date:	10/8/2010	Barrier #:	419A
Location:	Paco Ct - South				
X Coordinate:	-121.31762				
Y Coordinate:	38.71414				
Barrier Area:	Sidewalks				
Barrier Type:	Cross Slope - Existing (5.0% or more)				
Code Ref:	CBC 1133B.7.1.3 and ADA/ABA 403.3

As Built Meas:	223	Quantity:	LF
Description:	Cross slope exceeds 2.0% (5.0% or more)		
As Built Desc:	5.7% cross slope		
Solution:	Demolish existing and construct new route		
Bar. Severity:	1 Necessary	Cost Estimate:	\$27,875.00
Implementation Priority:	4	Facility Function:	
Implementation Phase:		Implementation Date:	
Official Responsible:			
Notes:

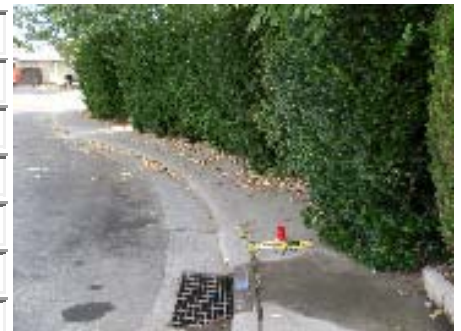
Field Date:	10/8/2010	Report Date:	10/8/2010	Barrier #:	419B
Location:	Paco Ct - South				
X Coordinate:	-121.31762				
Y Coordinate:	38.71413				
Barrier Area:	Sidewalks				
Barrier Type:	Clear Width - Existing ($\leq 31"$ or less)				
Code Ref:	CBC 1133B.7.1

As Built Meas:	1	Quantity:	LF
Description:	Pedestrian route is not min. 48" wide ($\leq 31"$ or less)		
As Built Desc:	30" clear width due to foliage		
Solution:	Trim foliage to provide min. 48" clear width		
Bar. Severity:	1 Necessary	Cost Estimate:	\$125.00
Implementation Priority:	4	Facility Function:	
Implementation Phase:		Implementation Date:	
Official Responsible:			
Notes:

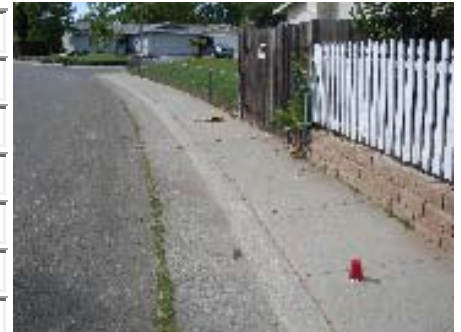
Barrier Type: Cross Slope - Existing (5.0% or more)

Code Ref: CBC 1133B.7.1.3 and ADA/ABA 403.3

As Built Meas: 180 Quantity: LF

Description: Cross slope exceeds 2.0% (5.0% or more)

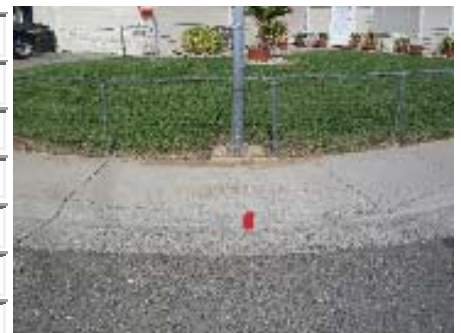
Barrier Type: No Curb Ramp - Depressed Existing Curb

Code Ref: CBC 1127B.5.1 and ADA/ABA 402.2

As Built Meas: 1 Quantity: EACH

Description: No compliant curb cut at corner (intersection)

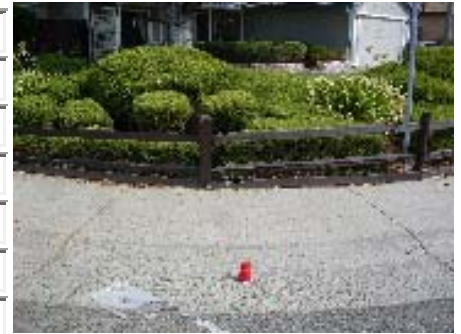
Field Date:	10/8/2010	Report Date:	10/8/2010	Barrier #:	422
Location:	Summerplace Dr and Gobi Ct - Corner B				
X Coordinate:	-121.31700				
Y Coordinate:	38.71349				
Barrier Area:	Curb Ramps				
Barrier Type:	No Curb Ramp - Depressed Exsiting Curb				
Code Ref:	CBC 1127B.5.1 and ADA/ABA 402.2

As Built Meas:	1	Quantity:	EACH
Description:	No compliant curb cut at corner (intersection)		
As Built Desc:	13.1% running slope at depressed area		
Solution:	Demolish existing and construct curb cut		
Bar. Severity:	1 Necessary	Cost Estimate:	\$2,500.00
Implementation Priority:	4	Facility Function:	
Implementation Phase:		Implementation Date:	
Official Responsible:			
Notes:	Four - way intersection corners A,B,C,D

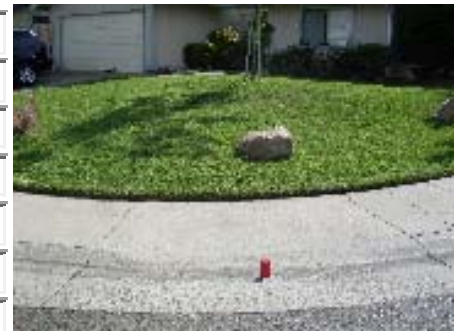
Field Date:	10/8/2010	Report Date:	10/8/2010	Barrier #:	423
Location:	Summerplace Dr and Gobi Ct - Corner C				
X Coordinate:	-121.31702				
Y Coordinate:	38.71339				
Barrier Area:	Curb Ramps				
Barrier Type:	No Curb Ramp - Depressed Exsiting Curb				
Code Ref:	CBC 1127B.5.1 and ADA/ABA 402.2

As Built Meas:	1	Quantity:	EACH
Description:	No compliant curb cut at corner (intersection)		
As Built Desc:	10.1% running slope at depressed area		
Solution:	Demolish existing and construct curb cut		
Bar. Severity:	1 Necessary	Cost Estimate:	\$2,500.00
Implementation Priority:	4	Facility Function:	
Implementation Phase:		Implementation Date:	
Official Responsible:			
Notes:	Four - way intersection corners A,B,C,D

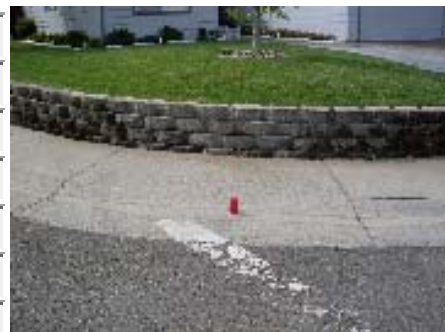
Barrier Type: No Curb Ramp - Depressed Exsiting Curb

Code Ref: CBC 1127B.5.1 and ADA/ABA 402.2

As Built Meas: 1 Quantity: EACH

Description: No compliant curb cut at corner (intersection)

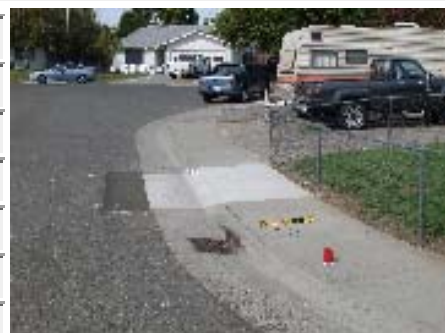
Barrier Type: Cross Slope - Existing (5.0% or more)

Code Ref: CBC 1133B.7.1.3 and ADA/ABA 403.3

As Built Meas: 184 Quantity: LF

Description: Cross slope exceeds 2.0% (5.0% or more)

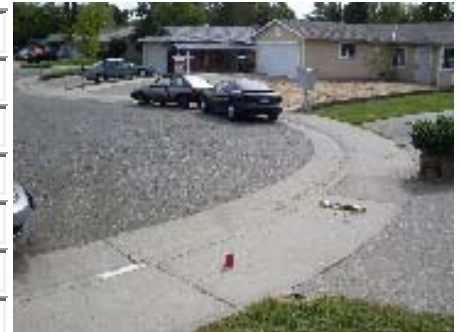
Field Date:	10/8/2010	Report Date:	10/8/2010	Barrier #:	426
Location:	Gobi Ct - South				
X Coordinate:	-121.31776				
Y Coordinate:	38.71341				
Barrier Area:	Sidewalks				
Barrier Type:	Cross Slope - Existing (5.0% or more)				
Code Ref:	CBC 1133B.7.1.3 and ADA/ABA 403.3

As Built Meas:	163	Quantity:	LF
Description:	Cross slope exceeds 2.0% (5.0% or more)		
As Built Desc:	5.0% cross slope		
Solution:	Demolish existing and construct new route		
Bar. Severity:	1 Necessary	Cost Estimate:	\$20,375.00
Implementation Priority:	4	Facility Function:	
Implementation Phase:		Implementation Date:	
Official Responsible:			
Notes:

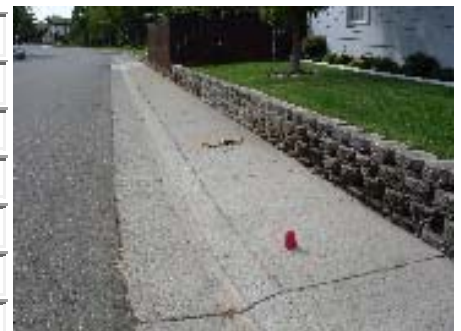
Field Date:	10/8/2010	Report Date:	10/8/2010	Barrier #:	427
Location:	Summerplace Dr - West				
X Coordinate:	-121.31725				
Y Coordinate:	38.71335				
Barrier Area:	Sidewalks				
Barrier Type:	Cross Slope - Existing (5.0% or more)				
Code Ref:	CBC 1133B.7.1.3 and ADA/ABA 403.3

As Built Meas:	193	Quantity:	LF
Description:	Cross slope exceeds 2.0% (5.0% or more)		
As Built Desc:	5.3% cross slope		
Solution:	Demolish existing and construct new route		
Bar. Severity:	1 Necessary	Cost Estimate:	\$24,125.00
Implementation Priority:	4	Facility Function:	
Implementation Phase:		Implementation Date:	
Official Responsible:			
Notes:

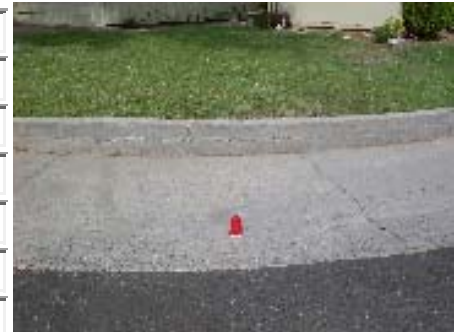
Field Date:	10/8/2010	Report Date:	10/8/2010	Barrier #:	428
Location:	Summerplace Dr and Beta Ct - Corner A				
X Coordinate:	-121.31721				
Y Coordinate:	38.71275				
Barrier Area:	Curb Ramps				
Barrier Type:	No Curb Ramp - Depressed Exsiting Curb				
Code Ref:	CBC 1127B.5.1 and ADA/ABA 402.2

As Built Meas:	1	Quantity:	EACH
Description:	No compliant curb cut at corner (intersection)		
As Built Desc:	13.3% running slope at depressed area		
Solution:	Demolish existing and construct curb cut		
Bar. Severity:	1 Necessary	Cost Estimate:	\$2,500.00
Implementation Priority:	4	Facility Function:	
Implementation Phase:		Implementation Date:	
Official Responsible:			
Notes:	Two - way intersection corners A,D

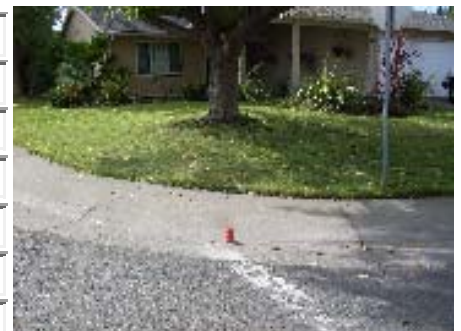
Field Date:	10/8/2010	Report Date:	10/8/2010	Barrier #:	431
Location:	Summerplace Dr and Beta Ct - Corner D				
X Coordinate:	-121.31727				
Y Coordinate:	38.71263				
Barrier Area:	Curb Ramps				
Barrier Type:	No Curb Ramp - Depressed Exsiting Curb				
Code Ref:	CBC 1127B.5.1 and ADA/ABA 402.2

As Built Meas:	1	Quantity:	EACH
Description:	No compliant curb cut at corner (intersection)		
As Built Desc:	13.9% running slope at depressed area		
Solution:	Demolish existing and construct curb cut		
Bar. Severity:	1 Necessary	Cost Estimate:	\$2,500.00
Implementation Priority:	4	Facility Function:	
Implementation Phase:		Implementation Date:	
Official Responsible:			
Notes:	Two - way intersection corners A,D

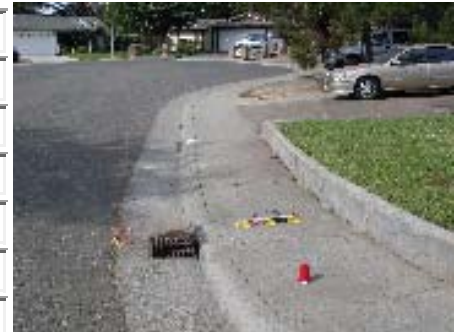
Field Date:	10/8/2010	Report Date:	10/8/2010	Barrier #:	429
Location:	Beta Ct - North				
X Coordinate:	-121.31722				
Y Coordinate:	38.71273				
Barrier Area:	Sidewalks				
Barrier Type:	Cross Slope - Existing (5.0% or more)				
Code Ref:	CBC 1133B.7.1.3 and ADA/ABA 403.3

As Built Meas:	183	Quantity:	LF
Description:	Cross slope exceeds 2.0% (5.0% or more)		
As Built Desc:	5.0% cross slope		
Solution:	Demolish existing and construct new route		
Bar. Severity:	1 Necessary	Cost Estimate:	\$22,875.00
Implementation Priority:	4	Facility Function:	
Implementation Phase:		Implementation Date:	
Official Responsible:			
Notes:
