DRAFT ADA TRANSITION PLAN UPDATE
NEIGHBORHOOD AREA 1 NORTHWEST
SEPTEMBER 20, 2011

CITY OF CITRUS HEIGHTS

The Northwest Neighborhood Association

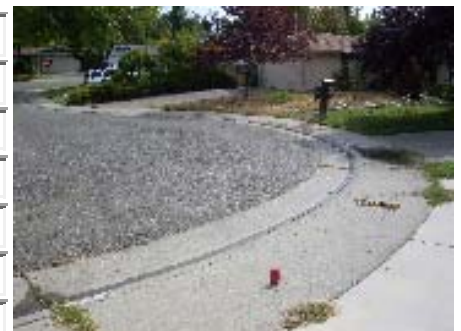
Field Date:	10/8/2010	Report Date:	10/8/2010	Barrier #:	430
Location:	Beta Ct - South				
X Coordinate:	-121.31723				
Y Coordinate:	38.71261				
Barrier Area:	Sidewalks				
Barrier Type:	Cross Slope - Existing (4.1% to 4.9%)				
Code Ref:	CBC 1133B.7.1.3 and ADA/ABA 403.3

As Built Meas:	144	Quantity:	LF
Description:	Cross slope exceeds 2.0% (4.1% to 4.9%)		
As Built Desc:	4.9% cross slope		
Solution:	Demolish existing and construct new route		
Bar. Severity:	2 Recommended	Cost Estimate:	\$18,000.00
Implementation Priority:	4	Facility Function:	
Implementation Phase:		Implementation Date:	
Official Responsible:			
Notes:

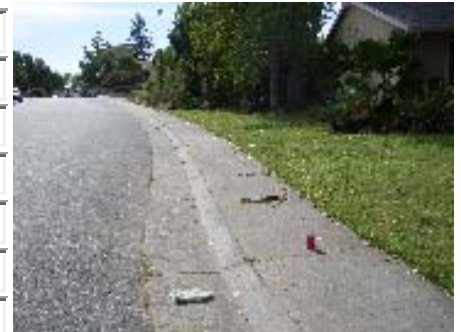
Field Date:	10/8/2010	Report Date:	10/8/2010	Barrier #:	432
Location:	Summerplace Dr - West				
X Coordinate:	-121.31689				
Y Coordinate:	38.71187				
Barrier Area:	Sidewalks				
Barrier Type:	Cross Slope - Existing (5.0% or more)				
Code Ref:	CBC 1133B.7.1.3 and ADA/ABA 403.3

As Built Meas:	175	Quantity:	LF
Description:	Cross slope exceeds 2.0% (5.0% or more)		
As Built Desc:	5.4% cross slope		
Solution:	Demolish existing and construct new route		
Bar. Severity:	1 Necessary	Cost Estimate:	\$21,875.00
Implementation Priority:	4	Facility Function:	
Implementation Phase:		Implementation Date:	
Official Responsible:			
Notes:

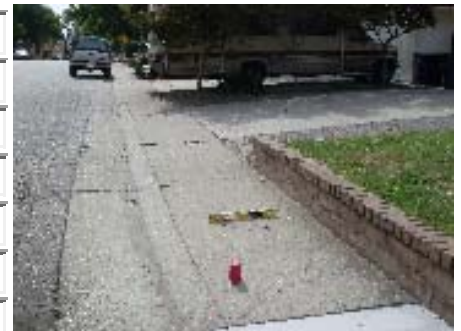
Field Date:	10/8/2010	Report Date:	10/8/2010	Barrier #:	433A
Location:	Summerplace Dr - West				
X Coordinate:	-121.31662				
Y Coordinate:	38.71132				
Barrier Area:	Sidewalks				
Barrier Type:	Cross Slope - Existing (5.0% or more)				
Code Ref:	CBC 1133B.7.1.3 and ADA/ABA 403.3

As Built Meas:	576	Quantity:	LF
Description:	Cross slope exceeds 2.0% (5.0% or more)		
As Built Desc:	6.2% cross slope		
Solution:	Demolish existing and construct new route		
Bar. Severity:	1 Necessary	Cost Estimate:	\$72,000.00
Implementation Priority:	4	Facility Function:	
Implementation Phase:		Implementation Date:	
Official Responsible:			
Notes:

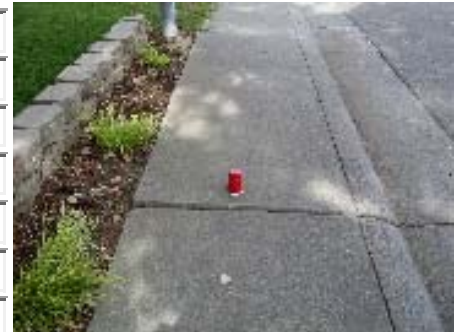
Field Date: 10/8/2010 Report Date: 10/8/2010 Barrier #: 433B

Barrier Type: Abrupt Change in Level - > 1/2"

As Built Meas: 4 Quantity: LF

Description: Change in level greater than 1/2"

Solution: Grind or repair sidewalk to remove trip hazard

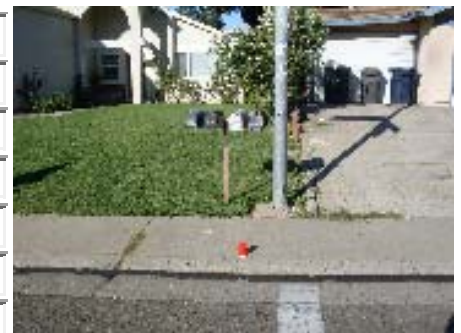
Barrier Type: No Curb Ramp

As Built Meas: 1 Quantity: EACH

Description: No curb cut at corner (intersection)

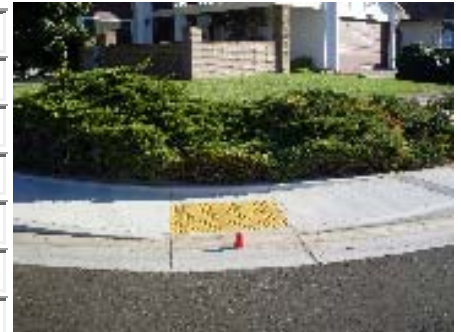
Field Date:	#####	Report Date:	10/12/2010	Barrier #:	435
Location:	Summerplace Dr and Carmelwood Dr - Corner B				
X Coordinate:	-121.31630				
Y Coordinate:	38.71032				
Barrier Area:	Curb Ramps				
Barrier Type:	12" Grooves - New Construction				
Code Ref:	CBC 1127B.5.6

As Built Meas:	1	Quantity:	EACH
Description:	12" grooves at top of curb ramp are not level (3.1% to 4.0%)		
As Built Desc:	3.9% at 12" grooves		
Solution:	Demolish existing and construct new curb ramp		
Bar. Severity:	1 Necessary	Cost Estimate:	\$2,500.00
Implementation Priority:	4	Facility Function:	
Implementation Phase:		Implementation Date:	
Official Responsible:			
Notes:	Three - way intersection corners A,B,C

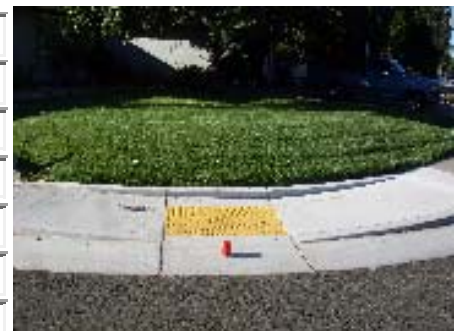
Field Date:	#####	Report Date:	10/12/2010	Barrier #:	436
Location:	Summerplace Dr and Carmelwood Dr - Corner C				
X Coordinate:	-121.31348				
Y Coordinate:	38.71123				
Barrier Area:	Curb Ramps				
Barrier Type:	12" Grooves - New Construction				
Code Ref:	CBC 1127B.5.6

As Built Meas:	1	Quantity:	EACH
Description:	12" grooves at top of curb ramp are not level (>5.0%)		
As Built Desc:	5.5% at 12" grooves - New Construction		
Solution:	Demolish existing and construct new curb ramp		
Bar. Severity:	1 Necessary	Cost Estimate:	\$2,500.00
Implementation Priority:	4	Facility Function:	
Implementation Phase:		Implementation Date:	
Official Responsible:			
Notes:	Three - way intersection corners A,B,C

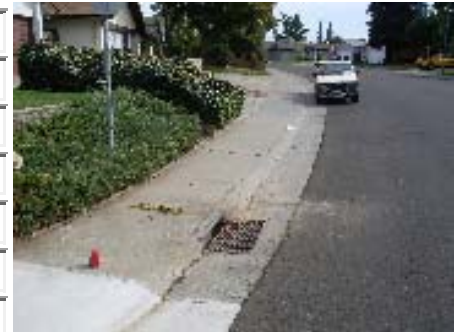
Field Date: 10/8/2010 Report Date: 10/8/2010 Barrier #: 437

Barrier Type: Cross Slope - Existing (4.1% to 4.9%)

As Built Meas: 311 Quantity: LF

Description: Cross slope exceeds 2.0% (4.1% to 4.9%)

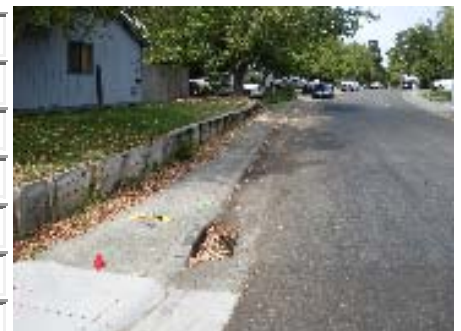
Barrier Type: Cross Slope - Existing (5.0% or more)

As Built Meas: 1060 Quantity: LF

Description: Cross slope exceeds 2.0% (5.0% or more)

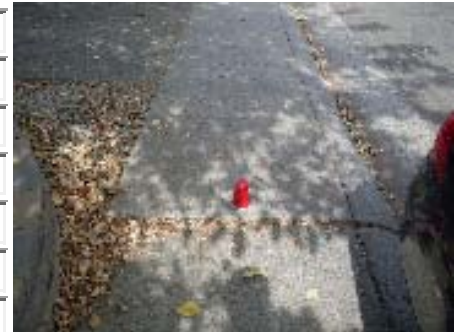
Barrier Type: Abrupt Change in Level - > 1/2"

As Built Meas: 4 Quantity: LF

Description: Change in level greater than 1/2"

Solution: Grind or repair sidewalk to remove trip hazard

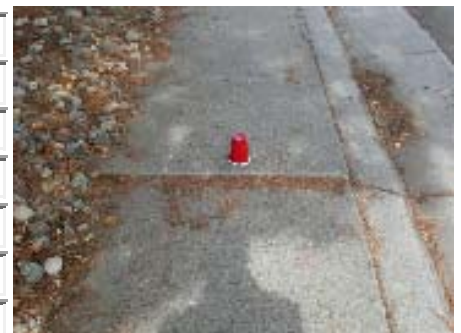
Barrier Type: Abrupt Change in Level - > 1/2"

As Built Meas: 4 Quantity: LF

Description: Change in level greater than 1/2"

Solution: Grind or repair sidewalk to remove trip hazard

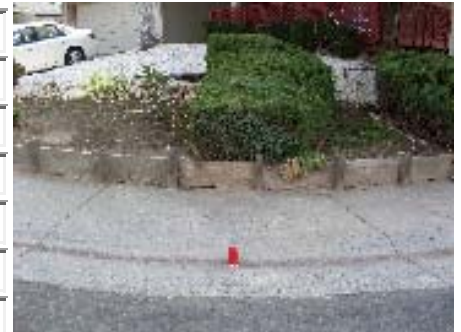
Field Date:	10/8/2010	Report Date:	10/8/2010	Barrier #:	439
Location:	Ramblewood Wy and Peppertree Wy - Corner C				
X Coordinate:	-121.31631				
Y Coordinate:	38.71336				
Barrier Area:	Curb Ramps				
Barrier Type:	No Curb Ramp - Depressed Exsiting Curb				
Code Ref:	CBC 1127B.5.1 and ADA/ABA 402.2

As Built Meas:	1	Quantity:	EACH
Description:	No compliant curb cut at corner (intersection)		
As Built Desc:	12.3% running slope at depressed area		
Solution:	Demolish existing and construct curb cut		
Bar. Severity:	1 Necessary	Cost Estimate:	\$2,500.00
Implementation Priority:	4	Facility Function:	
Implementation Phase:		Implementation Date:	
Official Responsible:			
Notes:	Two - way intersection corners C,D

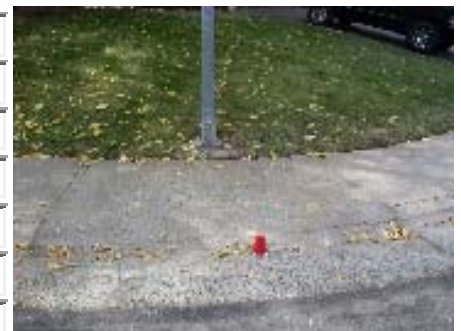
Field Date:	10/8/2010	Report Date:	10/8/2010	Barrier #:	440
Location:	Ramblewood Wy and Peppertree Wy - Corner D				
X Coordinate:	-121.31647				
Y Coordinate:	38.71330				
Barrier Area:	Curb Ramps				
Barrier Type:	No Curb Ramp - Depressed Exsiting Curb				
Code Ref:	CBC 1127B.5.1 and ADA/ABA 402.2

As Built Meas:	1	Quantity:	EACH
Description:	No compliant curb cut at corner (intersection)		
As Built Desc:	10.9% running slope at depressed area		
Solution:	Demolish existing and construct curb cut		
Bar. Severity:	1 Necessary	Cost Estimate:	\$2,500.00
Implementation Priority:	4	Facility Function:	
Implementation Phase:		Implementation Date:	
Official Responsible:			
Notes:	Two - way intersection corners C,D

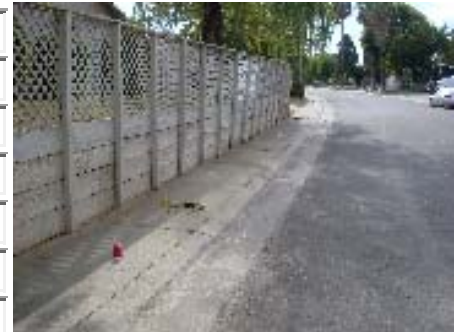
Field Date: 10/8/2010 Report Date: 10/8/2010 Barrier #: 441A

Barrier Type: Cross Slope - Existing (5.0% or more)

As Built Meas: 1020 Quantity: LF

Description: Cross slope exceeds 2.0% (5.0% or more)

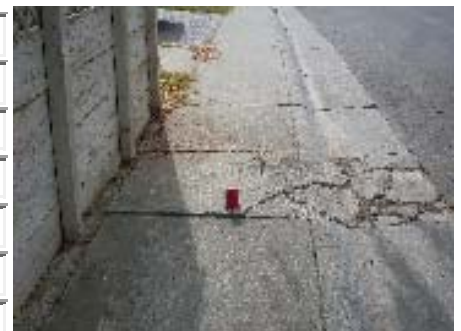
Barrier Type: Abrupt Change in Level - Tree Heaves

As Built Meas: 4 Quantity: LF

Description: Change in level greater than 1/2"

Solution: Grind or repair sidewalk to remove trip hazard

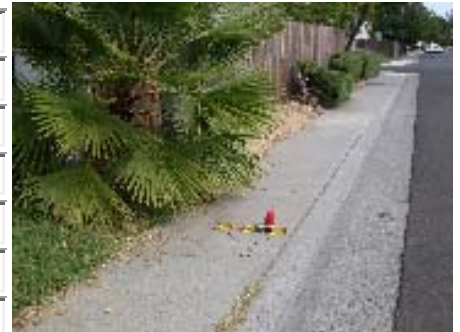
Field Date:	10/8/2010	Report Date:	10/8/2010	Barrier #:	442
Location:	Carmelwood Dr - West				
X Coordinate:	-121.31475				
Y Coordinate:	38.71077				
Barrier Area:	Sidewalks				
Barrier Type:	Clear Width - Existing ($\leq 31"$ or less)				
Code Ref:	CBC 1133B.7.1

As Built Meas:	1	Quantity:	LF
Description:	Pedestrian route is not min. 48" wide ($\leq 31"$ or less)		
As Built Desc:	26" clear width due to foliage		
Solution:	Trim foliage to provide min. 48" clear width		
Bar. Severity:	1 Necessary	Cost Estimate:	\$125.00
Implementation Priority:	4	Facility Function:	
Implementation Phase:		Implementation Date:	
Official Responsible:

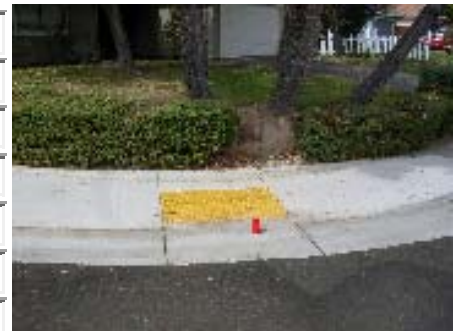
Field Date:	10/8/2010	Report Date:	10/8/2010	Barrier #:	443
Location:	Carmelwood Dr and Ramblewood Wy - Corner A				
X Coordinate:	-121.31446				
Y Coordinate:	38.71095				
Barrier Area:	Curb Ramps				
Barrier Type:	12" Grooves - New Construction				
Code Ref:	CBC 1127B.5.6

As Built Meas:	1	Quantity:	EACH
Description:	12" grooves at top of curb ramp are not level ($>5.0\%$)		
As Built Desc:	5.5% at 12" grooves - New Construction		
Solution:	Demolish existing and construct new curb ramp		
Bar. Severity:	1 Necessary	Cost Estimate:	\$2,500.00
Implementation Priority:	4	Facility Function:	
Implementation Phase:		Implementation Date:	
Official Responsible:

Notes:	Two - way intersection corners A,B. Corner B compliant
--------	--

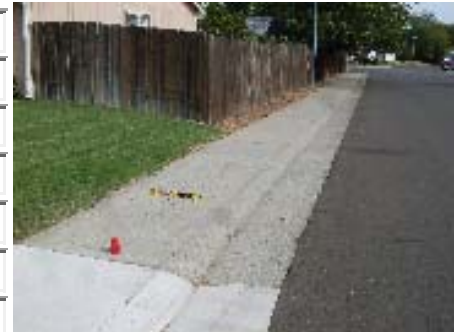
Field Date:	10/8/2010	Report Date:	10/8/2010	Barrier #:	444
Location:	Carmelwood Dr - West				
X Coordinate:	-121.31428				
Y Coordinate:	38.71101				
Barrier Area:	Sidewalks				
Barrier Type:	Cross Slope - Existing (4.1% to 4.9%)				
Code Ref:	CBC 1133B.7.1.3 and ADA/ABA 403.3

As Built Meas:	200	Quantity:	LF
Description:	Cross slope exceeds 2.0% (4.1% to 4.9%)		
As Built Desc:	4.2% cross slope		
Solution:	Demolish existing and construct new route		
Bar. Severity:	2 Recommended	Cost Estimate:	\$25,000.00
Implementation Priority:	4	Facility Function:	
Implementation Phase:		Implementation Date:	
Official Responsible:			
Notes:

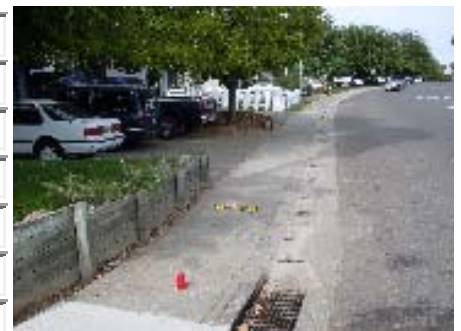
Field Date:	10/8/2010	Report Date:	10/8/2010	Barrier #:	445A
Location:	Summerplace Dr - South				
X Coordinate:	-121.31370				
Y Coordinate:	38.71141				
Barrier Area:	Sidewalks				
Barrier Type:	Cross Slope - Existing (5.0% or more)				
Code Ref:	CBC 1133B.7.1.3 and ADA/ABA 403.3

As Built Meas:	986	Quantity:	LF
Description:	Cross slope exceeds 2.0% (5.0% or more)		
As Built Desc:	5.3% cross slope		
Solution:	Demolish existing and construct new route		
Bar. Severity:	1 Necessary	Cost Estimate:	\$123,250.00
Implementation Priority:	4	Facility Function:	
Implementation Phase:		Implementation Date:	
Official Responsible:			
Notes:

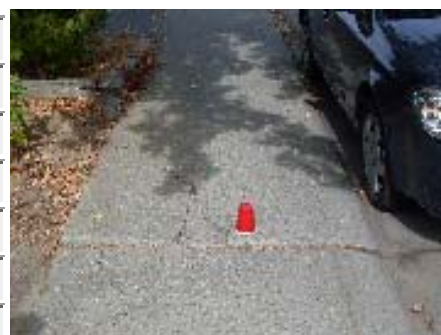
Field Date: 10/8/2010 Report Date: 10/8/2010 Barrier #: 445B

Barrier Type: Abrupt Change in Level - > 1/2"

As Built Meas: 4 Quantity: LF

Description: Change in level greater than 1/2"

Solution: Grind or repair sidewalk to remove trip hazard

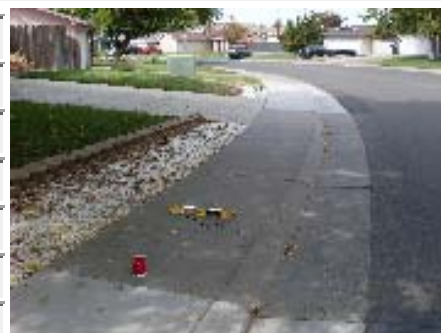
Barrier Type: Cross Slope - Existing (4.1% to 4.9%)

As Built Meas: 517 Quantity: LF

Description: Cross slope exceeds 2.0% (4.1% to 4.9%)

Bar. Severity: 2 Recommended Cost Estimate: \$64,625.00 Status:

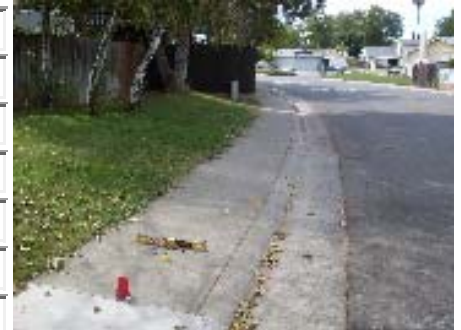
Barrier Type: Cross Slope - Existing (5.0% or more)

As Built Meas: 168 Quantity: LF

Description: Cross slope exceeds 2.0% (5.0% or more)

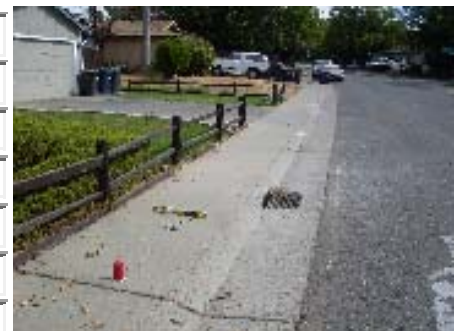
Barrier Type: Cross Slope - Existing (4.1% to 4.9%)

As Built Meas: 163 Quantity: LF

Description: Cross slope exceeds 2.0% (4.1% to 4.9%)

Bar. Severity: 2 Recommended

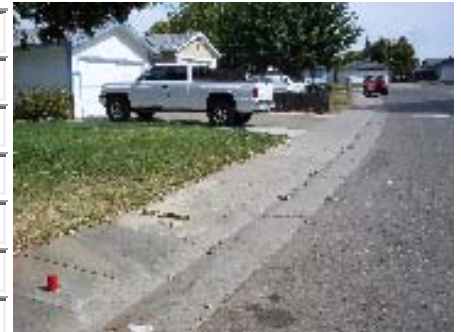
Barrier Type: Elbow in Sidewalk - Cross Slope (5.0% or more)

As Built Meas: 10 Quantity: LF

Description: Cross slope at elbow exceeds 2.0% (5.0% or more)

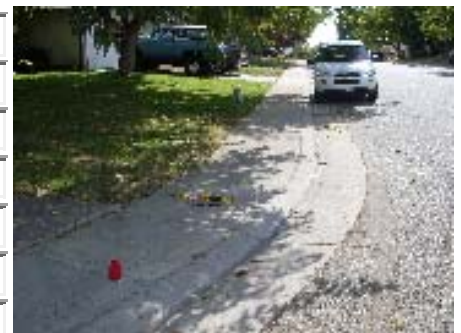
Barrier Type: Cross Slope - Existing (5.0% or more)

As Built Meas: 189 Quantity: LF

Description: Cross slope exceeds 2.0% (5.0% or more)

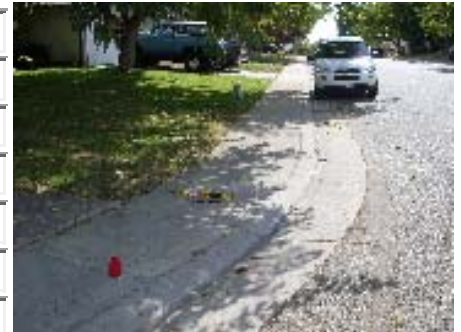
Barrier Type: Cross Slope - Existing (5.0% or more)

As Built Meas: 955 Quantity: LF

Description: Cross slope exceeds 2.0% (5.0% or more)

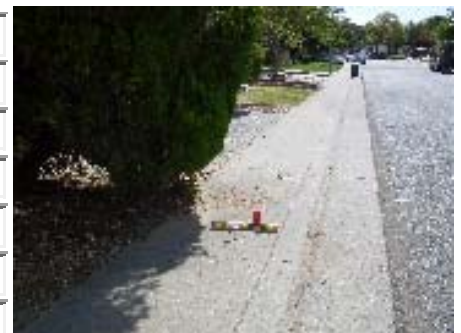
Barrier Type: Clear Width - Existing (32" to 35")

As Built Meas: 1 Quantity: LF

Description: Pedestrian route is not min. 48" wide (32" to 35")

Bar. Severity: 2 Recommended Cost Estimate: \$125.00 Status:

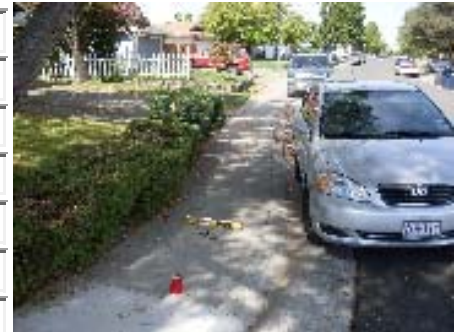
Field Date:	10/8/2010	Report Date:	10/8/2010	Barrier #:	452
Location:	Ramblewood Wy - West				
X Coordinate:	-121.31446				
Y Coordinate:	38.71095				
Barrier Area:	Sidewalks				
Barrier Type:	Cross Slope - Existing (4.1% to 4.9%)				
Code Ref:	CBC 1133B.7.1.3 and ADA/ABA 403.3

As Built Meas:	971	Quantity:	LF
Description:	Cross slope exceeds 2.0% (4.1% to 4.9%)		
As Built Desc:	4.9% cross slope		
Solution:	Demolish existing and construct new route		
Bar. Severity:	2 Recommended	Cost Estimate:	\$121,375.00
Implementation Priority:	4	Facility Function:	
Implementation Phase:		Implementation Date:	
Official Responsible:

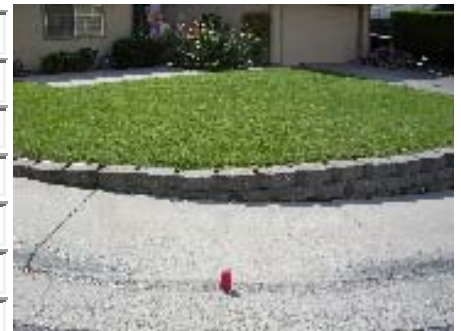
Field Date:	10/8/2010	Report Date:	10/8/2010	Barrier #:	453
Location:	Ramblewood Wy - West				
X Coordinate:	-121.31570				
Y Coordinate:	38.71345				
Barrier Area:	Sidewalks				
Barrier Type:	Elbow in Sidewalk - Cross Slope (5.0% or more)				
Code Ref:	CBC 1133B.7.1.3 and ADA/ABA 403.3

As Built Meas:	10	Quantity:	LF
Description:	Cross slope at elbow exceeds 2.0% (5.0% or more)		
As Built Desc:	13.1% cross slope		
Solution:	Demolish existing and construct new sidewalk without curb ramp		
Bar. Severity:	1 Necessary	Cost Estimate:	\$1,250.00
Implementation Priority:	4	Facility Function:	
Implementation Phase:		Implementation Date:	
Official Responsible:

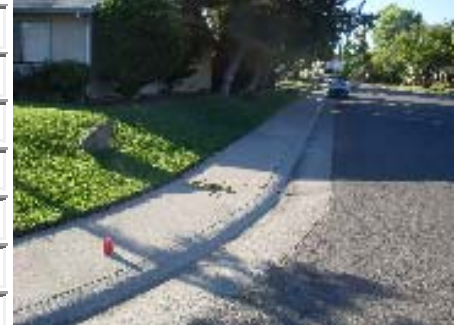
Field Date:	#####	Report Date:	10/12/2010	Barrier #:	455
Location:	Summerplace Dr - East				
X Coordinate:	-121.31705				
Y Coordinate:	38.71332				
Barrier Area:	Sidewalks				
Barrier Type:	Cross Slope - Existing (4.1% to 4.9%)				
Code Ref:	CBC 1133B.7.1.3 and ADA/ABA 403.3

As Built Meas:	1063	Quantity:	LF
Description:	Cross slope exceeds 2.0% (4.1% to 4.9%)		
As Built Desc:	4.9% cross slope		
Solution:	Demolish existing and construct new route		
Bar. Severity:	2 Recommended	Cost Estimate:	\$132,875.00
Implementation Priority:	4	Facility Function:	
Implementation Phase:		Implementation Date:	
Official Responsible:			
Notes:

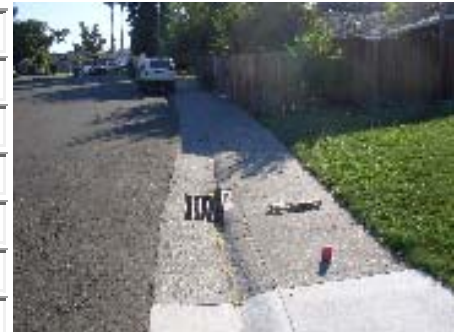
Field Date:	#####	Report Date:	10/12/2010	Barrier #:	456
Location:	Carmelwood Dr - South				
X Coordinate:	-121.31630				
Y Coordinate:	38.71018				
Barrier Area:	Sidewalks				
Barrier Type:	Cross Slope - Existing (4.1% to 4.9%)				
Code Ref:	CBC 1133B.7.1.3 and ADA/ABA 403.3

As Built Meas:	876	Quantity:	LF
Description:	Cross slope exceeds 2.0% (4.1% to 4.9%)		
As Built Desc:	4.2% cross slope		
Solution:	Demolish existing and construct new route		
Bar. Severity:	2 Recommended	Cost Estimate:	\$109,500.00
Implementation Priority:	4	Facility Function:	
Implementation Phase:		Implementation Date:	
Official Responsible:			
Notes:

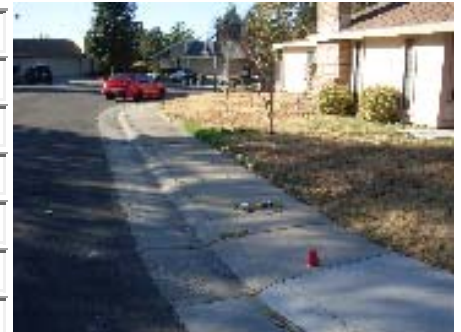
Field Date:	#####	Report Date:	10/12/2010	Barrier #:	458
Location:	Candy Cone Ct - West				
X Coordinate:	-121.31222				
Y Coordinate:	38.71149				
Barrier Area:	Sidewalks				
Barrier Type:	Cross Slope - Existing (5.0% or more)				
Code Ref:	CBC 1133B.7.1.3 and ADA/ABA 403.3

As Built Meas:	193	Quantity:	LF
Description:	Cross slope exceeds 2.0% (5.0% or more)		
As Built Desc:	6.4% cross slope		
Solution:	Demolish existing and construct new route		
Bar. Severity:	1 Necessary	Cost Estimate:	\$24,125.00
Implementation Priority:	4	Facility Function:	
Implementation Phase:		Implementation Date:	
Official Responsible:			
Notes:

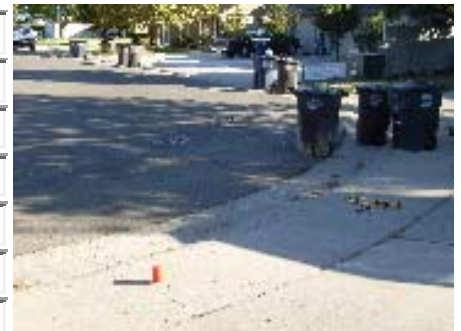
Field Date:	#####	Report Date:	10/12/2010	Barrier #:	459
Location:	Candy Cone Ct - East				
X Coordinate:	-121.31225				
Y Coordinate:	38.71102				
Barrier Area:	Sidewalks				
Barrier Type:	Cross Slope - Existing (4.1% to 4.9%)				
Code Ref:	CBC 1133B.7.1.3 and ADA/ABA 403.3

As Built Meas:	176	Quantity:	LF
Description:	Cross slope exceeds 2.0% (4.1% to 4.9%)		
As Built Desc:	4.7% cross slope		
Solution:	Demolish existing and construct new route		
Bar. Severity:	2 Recommended	Cost Estimate:	\$22,000.00
Implementation Priority:	4	Facility Function:	
Implementation Phase:		Implementation Date:	
Official Responsible:			
Notes:

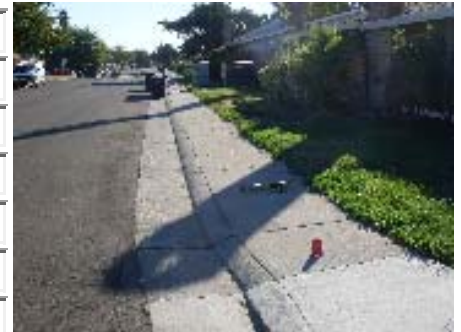
Field Date:	#####	Report Date:	10/12/2010	Barrier #:	460
Location:	Carmelwood Dr - South				
X Coordinate:	-121.31209				
Y Coordinate:	38.71152				
Barrier Area:	Sidewalks				
Barrier Type:	Cross Slope - Existing (4.1% to 4.9%)				
Code Ref:	CBC 1133B.7.1.3 and ADA/ABA 403.3

As Built Meas:	180	Quantity:	LF
Description:	Cross slope exceeds 2.0% (4.1% to 4.9%)		
As Built Desc:	4.5% cross slope		
Solution:	Demolish existing and construct new route		
Bar. Severity:	2 Recommended	Cost Estimate:	\$22,500.00
Implementation Priority:	4	Facility Function:	
Implementation Phase:		Implementation Date:	
Official Responsible:

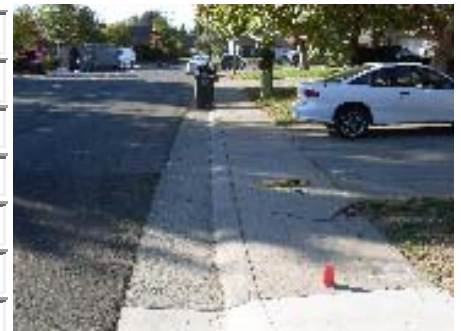
Field Date:	#####	Report Date:	10/12/2010	Barrier #:	461
Location:	Zenith Dr - West				
X Coordinate:	-121.31134				
Y Coordinate:	38.71149				
Barrier Area:	Sidewalks				
Barrier Type:	Cross Slope - Existing (4.1% to 4.9%)				
Code Ref:	CBC 1133B.7.1.3 and ADA/ABA 403.3

As Built Meas:	453	Quantity:	LF
Description:	Cross slope exceeds 2.0% (4.1% to 4.9%)		
As Built Desc:	4.7% cross slope		
Solution:	Demolish existing and construct new route		
Bar. Severity:	2 Recommended	Cost Estimate:	\$56,625.00
Implementation Priority:	3	Facility Function:	
Implementation Phase:		Implementation Date:	
Official Responsible:

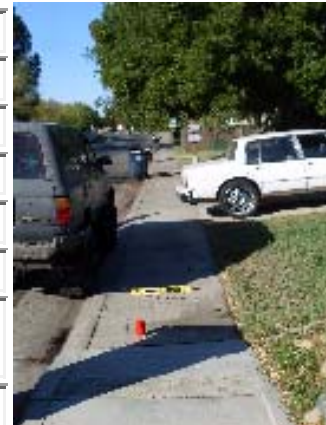
Field Date:	#####	Report Date:	10/12/2010	Barrier #:	462
Location:	Zenith Dr - North				
X Coordinate:	-121.31208				
Y Coordinate:	38.71043				
Barrier Area:	Sidewalks				
Barrier Type:	Cross Slope - Existing (4.1% to 4.9%)				
Code Ref:	CBC 1133B.7.1.3 and ADA/ABA 403.3

As Built Meas:	230	Quantity:	LF
Description:	Cross slope exceeds 2.0% (4.1% to 4.9%)		
As Built Desc:	4.6% cross slope		
Solution:	Demolish existing and construct new route		
Bar. Severity:	2 Recommended	Cost Estimate:	\$28,750.00
Implementation Priority:	3	Facility Function:	
Implementation Phase:		Implementation Date:	
Official Responsible:

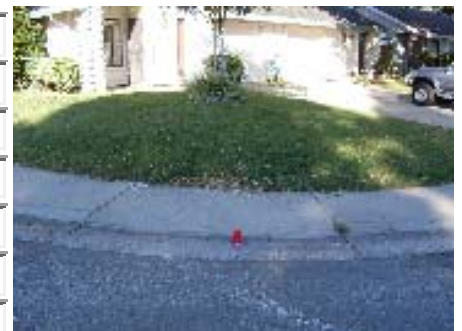
Field Date:	#####	Report Date:	10/12/2010	Barrier #:	463
Location:	Zenith Dr and Summerplace Dr - Corner A				
X Coordinate:	-121.31314				
Y Coordinate:	38.71019				
Barrier Area:	Curb Ramps				
Barrier Type:	No Curb Ramp - Depressed Existing Curb				
Code Ref:	CBC 1127B.5.1 and ADA/ABA 402.2

As Built Meas:	1	Quantity:	EACH
Description:	No compliant curb cut at corner (intersection)		
As Built Desc:	12.7% running slope at depressed area		
Solution:	Demolish existing and construct curb cut		
Bar. Severity:	1 Necessary	Cost Estimate:	\$2,500.00
Implementation Priority:	3	Facility Function:	
Implementation Phase:		Implementation Date:	
Official Responsible:

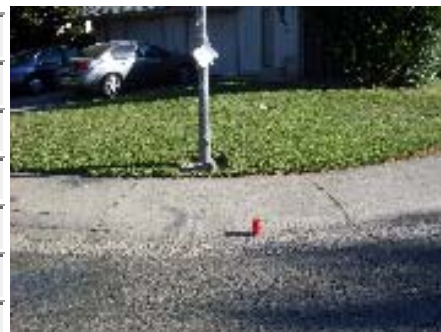
Barrier Type: No Curb Ramp - Depressed Exsiting Curb

Description: No compliant curb cut at corner (intersection)

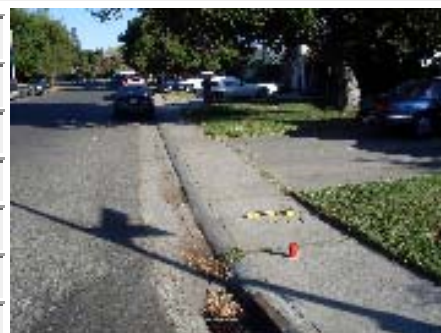
Barrier Type: Cross Slope - Existing (4.1% to 4.9%)

Description: Cross slope exceeds 2.0% (4.1% to 4.9%)

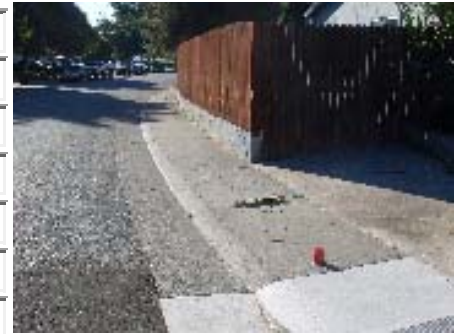
Field Date:	#####	Report Date:	10/12/2010	Barrier #:	466
Location:	Summerplace Dr - West				
X Coordinate:	-121.31359				
Y Coordinate:	38.71103				
Barrier Area:	Sidewalks				
Barrier Type:	Cross Slope - Existing (5.0% or more)				
Code Ref:	CBC 1133B.7.1.3 and ADA/ABA 403.3

As Built Meas:	360	Quantity:	LF	
Description:	Cross slope exceeds 2.0% (5.0% or more)			
As Built Desc:	5.7% cross slope			
Solution:	Demolish existing and construct new route			
Bar. Severity:	1 Necessary	Cost Estimate:	\$45,000.00	Status:
Implementation Priority:	4	Facility Function:		
Implementation Phase:		Implementation Date:		
Official Responsible:				
Notes:

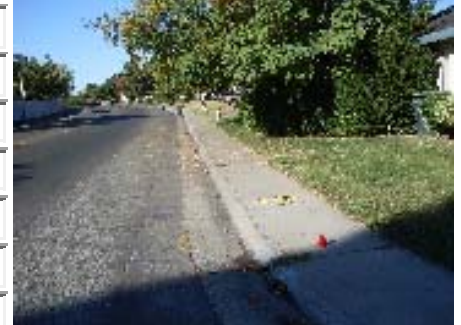
Field Date:	#####	Report Date:	10/12/2010	Barrier #:	467A
Location:	Zenith Dr - North				
X Coordinate:	-121.31317				
Y Coordinate:	38.71021				
Barrier Area:	Sidewalks				
Barrier Type:	Cross Slope - Existing (5.0% or more)				
Code Ref:	CBC 1133B.7.1.3 and ADA/ABA 403.3

As Built Meas:	650	Quantity:	LF	
Description:	Cross slope exceeds 2.0% (5.0% or more)			
As Built Desc:	6.0% cross slope			
Solution:	Demolish existing and construct new route			
Bar. Severity:	1 Necessary	Cost Estimate:	\$81,250.00	Status:
Implementation Priority:	3	Facility Function:		
Implementation Phase:		Implementation Date:		
Official Responsible:				
Notes:

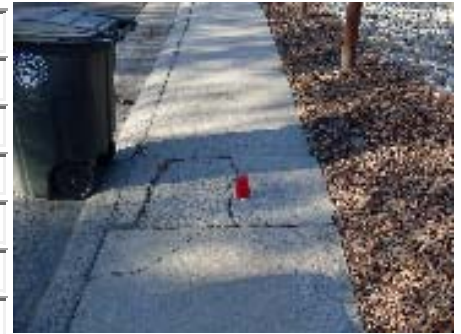
Barrier Type: Surface Condition - Damaged

Description: Surface is not firm and stable (cracked, broken or loose soil, etc.)

As Built Desc: Cracked concrete

Solution: Repair surface to make firm and stable

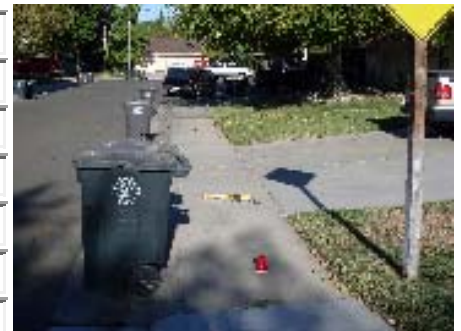
Barrier Type: Cross Slope - Existing (5.0% or more)

Description: Cross slope exceeds 2.0% (5.0% or more)

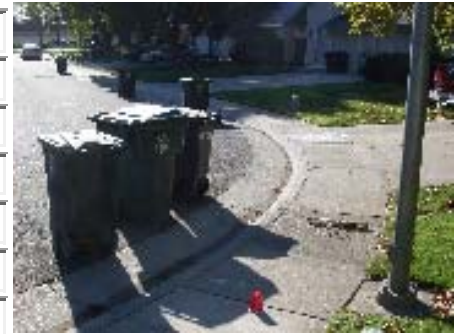
Field Date:	#####	Report Date:	10/12/2010	Barrier #:	469
Location:	Sorrell Ct - South				
X Coordinate:	-121.31574				
Y Coordinate:	38.70953				
Barrier Area:	Sidewalks				
Barrier Type:	Cross Slope - Existing (5.0% or more)				
Code Ref:	CBC 1133B.7.1.3 and ADA/ABA 403.3

As Built Meas:	211	Quantity:	LF
Description:	Cross slope exceeds 2.0% (5.0% or more)		
As Built Desc:	5.6% cross slope		
Solution:	Demolish existing and construct new route		
Bar. Severity:	1 Necessary	Cost Estimate:	\$26,375.00
Implementation Priority:	4	Facility Function:	
Implementation Phase:		Implementation Date:	
Official Responsible:			
Notes:

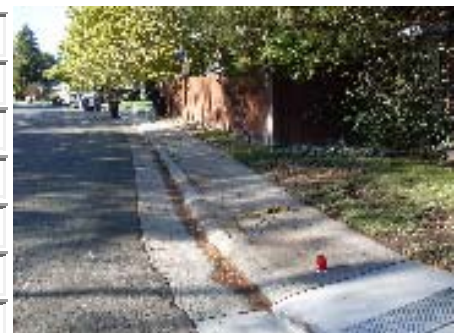
Field Date:	#####	Report Date:	10/12/2010	Barrier #:	470
Location:	Zenith Dr - West				
X Coordinate:	-121.31524				
Y Coordinate:	38.70911				
Barrier Area:	Sidewalks				
Barrier Type:	Cross Slope - Existing (5.0% or more)				
Code Ref:	CBC 1133B.7.1.3 and ADA/ABA 403.3

As Built Meas:	270	Quantity:	LF
Description:	Cross slope exceeds 2.0% (5.0% or more)		
As Built Desc:	5.4% cross slope		
Solution:	Demolish existing and construct new route		
Bar. Severity:	1 Necessary	Cost Estimate:	\$33,750.00
Implementation Priority:	3	Facility Function:	
Implementation Phase:		Implementation Date:	
Official Responsible:			
Notes:

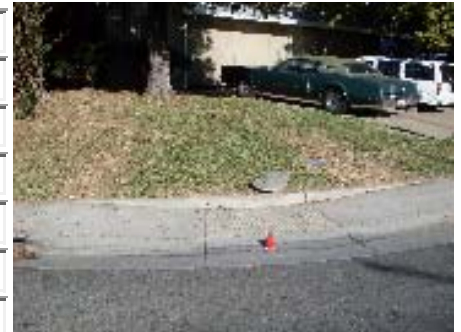
Barrier Type: 12" Grooves - Existing (4.1% to 4.9%)

Description: 12" grooves at top of curb ramp are not level (4.1% to 4.9%)

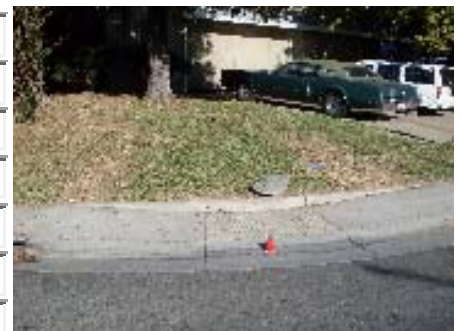
Barrier Type: Parallel Ramp Landing - Existing (3.1% to 4.0%)

Description: Curb ramp landing or pan not level (3.1% to 4.0%)

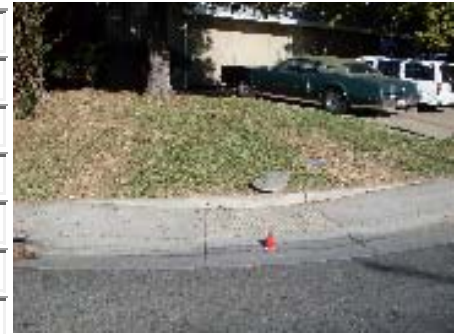
Barrier Type: Detectable Warnings - Truncated Domes

Description: No truncated domes provided at curb ramp

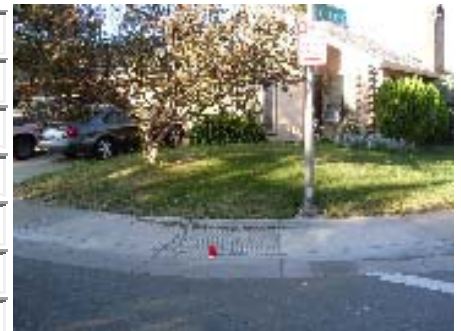
Barrier Type: Detectable Warnings - Truncated Domes

Description: No truncated domes provided at curb ramp

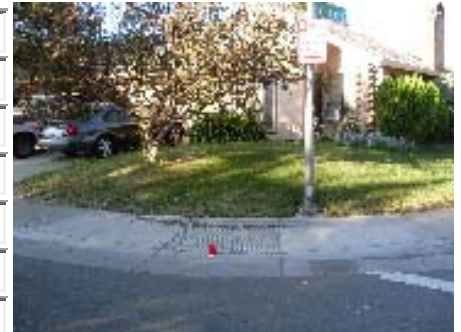
Barrier Type: Gutter Slope - Existing (5.9% - 6.5%)

Description: Gutter slope exceeds 5.0% (5.9% - 6.5%)

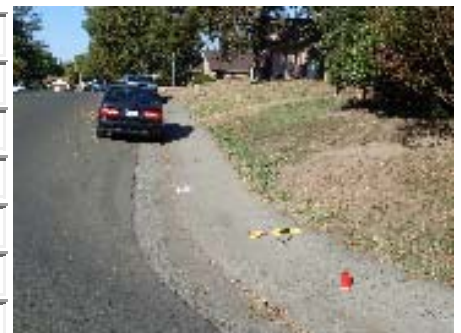
Barrier Type: Cross Slope - Existing (5.0% or more)

Description: Cross slope exceeds 2.0% (5.0% or more)

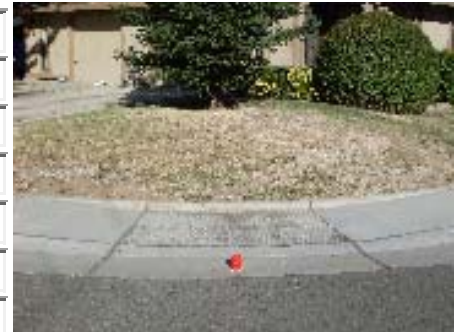
Field Date:	#####	Report Date:	10/12/2010	Barrier #:	474A
Location:	Blackstar Dr and Cobra Ct - Corner A				
X Coordinate:	-121.31635				
Y Coordinate:	38.70842				
Barrier Area:	Curb Ramps				
Barrier Type:	12" Grooves - Existing (2.1% to 3.0%)				
Code Ref:	CBC 1127B.5.6

As Built Meas:	1	Quantity:	EACH		
Description:	12" grooves at top of curb ramp are not level (2.1% to 3.0%)				
As Built Desc:	2.9% at 12" grooves				
Solution:	Demolish existing and construct new curb ramp				
Bar. Severity:	4 Low Severity	Cost Estimate:	\$2,500.00	Status:	
Implementation Priority:	4	Facility Function:			
Implementation Phase:		Implementation Date:			
Official Responsible:					
Notes:	Four - way intersection corners A,B,C,D

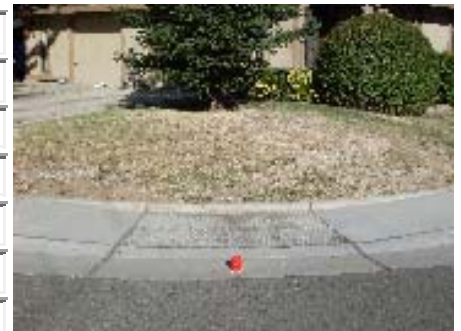
Field Date:	#####	Report Date:	10/12/2010	Barrier #:	474B
Location:	Blackstar Dr and Cobra Ct - Corner A				
X Coordinate:	-121.31635				
Y Coordinate:	38.70842				
Barrier Area:	Curb Ramps				
Barrier Type:	Detectable Warnings - Truncated Domes				
Code Ref:	CBC 1127B.5.7 and ADA/ABA 705.1.3

As Built Meas:	1	Quantity:	EACH		
Description:	No truncated domes provided at curb ramp				
As Built Desc:	No detectable warnings at curb ramp				
Solution:	Provide compliant truncated domes				
Bar. Severity:	2 Recommended	Cost Estimate:	\$0.00	Status:	
Implementation Priority:	4	Facility Function:			
Implementation Phase:		Implementation Date:			
Official Responsible:					
Notes:	Four - way intersection corners A,B,C,D

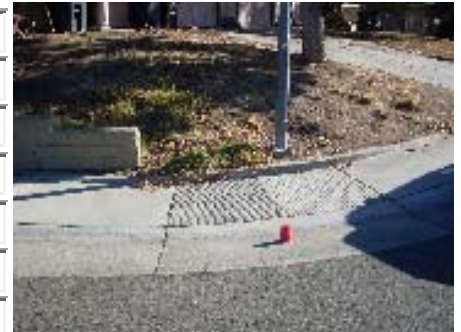
Barrier Type: 12" Grooves - Existing (3.1% to 4.0%)

Description: 12" grooves at top of curb ramp are not level (3.1% to 4.0%)

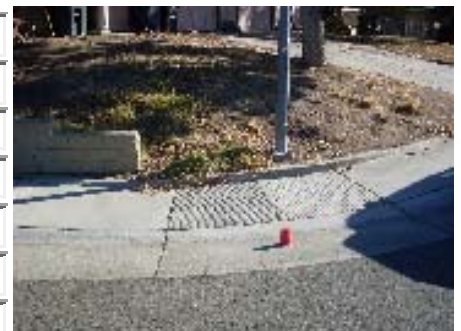
Barrier Type: Gutter Slope - Existing (6.6% to 8.2%)

Description: Gutter slope exceeds 5.0% (6.6% to 8.2%)

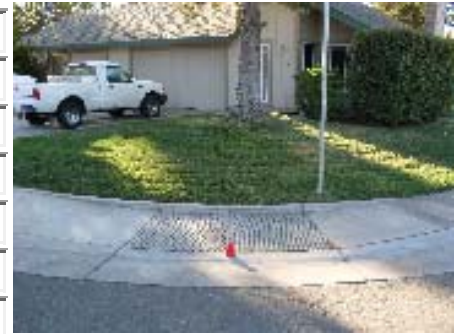
Barrier Type: Gutter Slope - Existing (6.6% to 8.2%)

Description: Gutter slope exceeds 5.0% (6.6% to 8.2%)

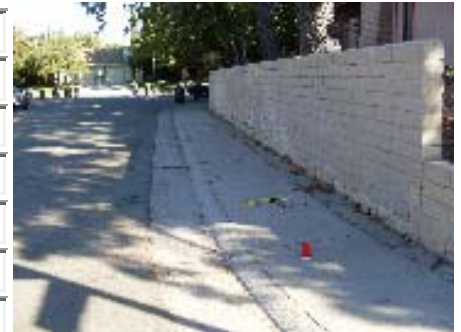
Field Date:	#####	Report Date:	10/12/2010	Barrier #:	478
Location:	Cobera Ct - East				
X Coordinate:	-121.31615				
Y Coordinate:	38.70847				
Barrier Area:	Sidewalks				
Barrier Type:	Cross Slope - Existing (4.1% to 4.9%)				
Code Ref:	CBC 1133B.7.1.3 and ADA/ABA 403.3

As Built Meas:	198	Quantity:	LF
Description:	Cross slope exceeds 2.0% (4.1% to 4.9%)		
As Built Desc:	4.6% cross slope		
Solution:	Demolish existing and construct new route		
Bar. Severity:	2 Recommended	Cost Estimate:	\$24,750.00
Implementation Priority:	4	Facility Function:	
Implementation Phase:		Implementation Date:	
Official Responsible:

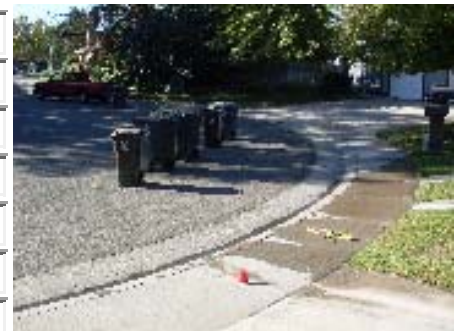
Field Date:	#####	Report Date:	10/12/2010	Barrier #:	479
Location:	Cobera Ct - West				
X Coordinate:	-121.31624				
Y Coordinate:	38.70893				
Barrier Area:	Sidewalks				
Barrier Type:	Cross Slope - Existing (5.0% or more)				
Code Ref:	CBC 1133B.7.1.3 and ADA/ABA 403.3

As Built Meas:	192	Quantity:	LF
Description:	Cross slope exceeds 2.0% (5.0% or more)		
As Built Desc:	5.1% cross slope		
Solution:	Demolish existing and construct new route		
Bar. Severity:	1 Necessary	Cost Estimate:	\$24,000.00
Implementation Priority:	4	Facility Function:	
Implementation Phase:		Implementation Date:	
Official Responsible:

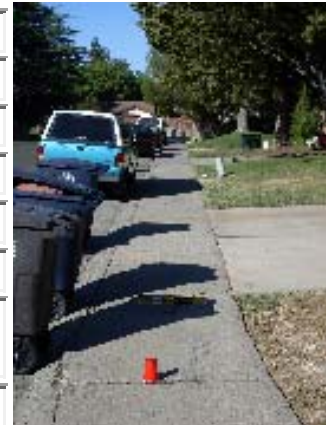
Barrier Type: Cross Slope - Existing (5.0% or more)

Code Ref: CBC 1133B.7.1.3 and ADA/ABA 403.3

As Built Meas: 300 Quantity: LF

Description: Cross slope exceeds 2.0% (5.0% or more)

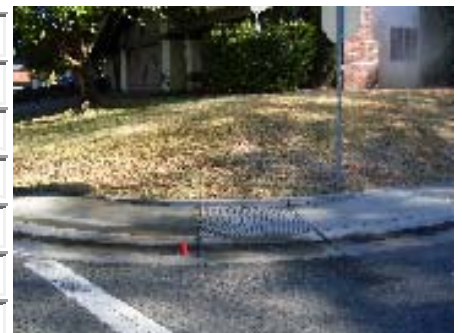
Barrier Type: Detectable Warnings - Truncated Domes

Code Ref: CBC 1127B.5.7 and ADA/ABA 705.1.3

As Built Meas: 1 Quantity: EACH

Description: No truncated domes provided at curb ramp

Bar. Severity: 2 Recommended Cost Estimate: \$2,500.00 Status:

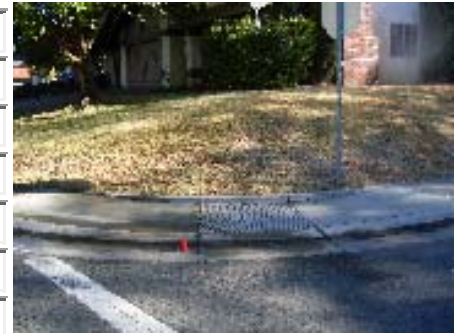
Barrier Type: 12" Grooves - Existing (3.1% to 4.0%)

Code Ref: CBC 1127B.5.6

As Built Meas: 1 Quantity: EACH

Description: 12" grooves at top of curb ramp are not level (3.1% to 4.0%)

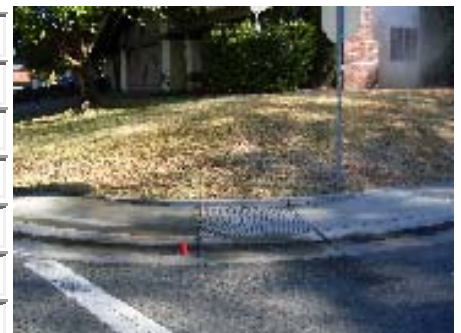
Barrier Type: Gutter Slope - Existing (6.6% to 8.2%)

Code Ref: CBC 1127B.5.3 and ADA/ABA 406.2

As Built Meas: 6 Quantity: SF

Description: Gutter slope exceeds 5.0% (6.6% to 8.2%)

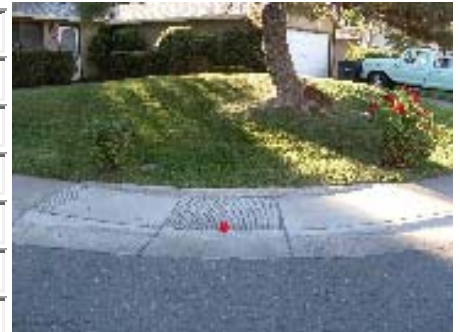
Field Date:	#####	Report Date:	10/13/2010	Barrier #:	482A
Location:	Blackstar Dr and Summerplace Dr - Corner C				
X Coordinate:	-121.31741				
Y Coordinate:	38.70834				
Barrier Area:	Curb Ramps				
Barrier Type:	Detectable Warnings - Truncated Domes				
Code Ref:	CBC 1127B.5.7 and ADA/ABA 705.1.3

As Built Meas:	1	Quantity:	EACH	
Description:	No truncated domes provided at curb ramp			
As Built Desc:	No detectable warnings at curb ramp			
Solution:	Provide compliant truncated domes			
Bar. Severity:	2 Recommended	Cost Estimate:	\$1,400.00	Status:
Implementation Priority:	4	Facility Function:		
Implementation Phase:		Implementation Date:		
Official Responsible:				
Notes:	Two - way intersection corners B,C

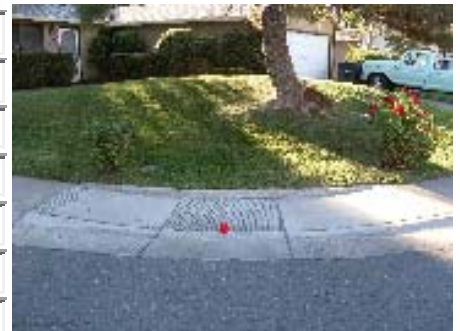
Field Date:	#####	Report Date:	10/13/2010	Barrier #:	482B
Location:	Blackstar Dr and Summerplace Dr - Corner C				
X Coordinate:	-121.31741				
Y Coordinate:	38.70834				
Barrier Area:	Curb Ramps				
Barrier Type:	Gutter Slope - Existing (8.3% or more)				
Code Ref:	CBC 1127B.5.3 and ADA/ABA 406.2

As Built Meas:	6	Quantity:	SF	
Description:	Gutter slope exceeds 5.0% (8.3% or more)			
As Built Desc:	10.8% gutter slope			
Solution:	Demolish existing and construct new gutter			
Bar. Severity:	1 Necessary	Cost Estimate:	\$750.00	Status:
Implementation Priority:	4	Facility Function:		
Implementation Phase:		Implementation Date:		
Official Responsible:				
Notes:	Two - way intersection corners B,C

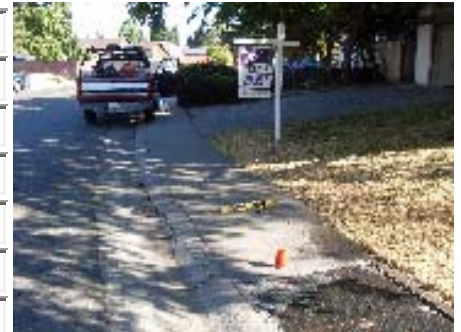
Field Date:	#####	Report Date:	10/12/2010	Barrier #:	483A
Location:	Summerplace Dr - East				
X Coordinate:	-121.31752				
Y Coordinate:	38.70846				
Barrier Area:	Sidewalks				
Barrier Type:	Cross Slope - Existing (5.0% or more)				
Code Ref:	CBC 1133B.7.1.3 and ADA/ABA 403.3

As Built Meas:	679	Quantity:	LF		
Description:	Cross slope exceeds 2.0% (5.0% or more)				
As Built Desc:	5.1% cross slope				
Solution:	Demolish existing and construct new route				
Bar. Severity:	1 Necessary	Cost Estimate:	\$84,875.00	Status:	
Implementation Priority:	4	Facility Function:			
Implementation Phase:		Implementation Date:			
Official Responsible:					
Notes:

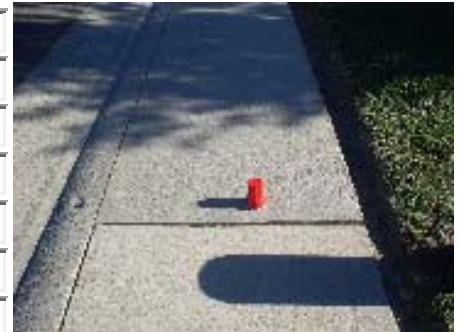
Barrier Type: Abrupt Change in Level - Tree Heaves

Code Ref: CBC 1133B.7.1 and ADA/ABA 303.3

As Built Meas: 4 Quantity: LF

Description: Change in level greater than 1/2"

Solution: Grind or repair sidewalk to remove trip hazard

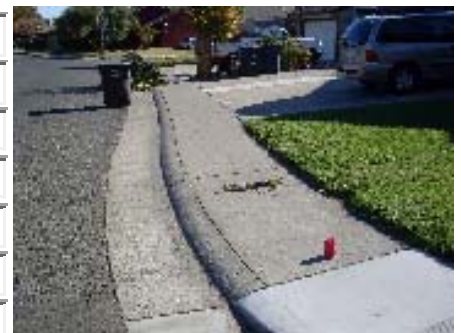
Barrier Type: Cross Slope - Existing (4.1% to 4.9%)

Code Ref: CBC 1133B.7.1.3 and ADA/ABA 403.3

As Built Meas: 107 Quantity: LF

Description: Cross slope exceeds 2.0% (4.1% to 4.9%)

Bar. Severity: 2 Recommended Cost Estimate: \$13,375.00 Status:

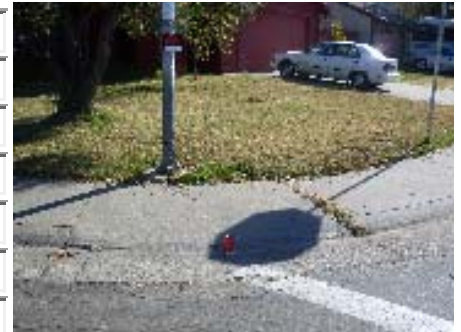
Field Date:	#####	Report Date:	10/12/2010	Barrier #:	485
Location:	Zenith Dr and Posten Wy - Corner B				
X Coordinate:	-121.31138				
Y Coordinate:	38.71062				
Barrier Area:	Curb Ramps				
Barrier Type:	No Curb Ramp - Depressed Exsiting Curb				
Code Ref:	CBC 1127B.5.1 and ADA/ABA 402.2

As Built Meas:	1	Quantity:	EACH
Description:	No compliant curb cut at corner (intersection)		
As Built Desc:	12.1% running slope at depressed area		
Solution:	Demolish existing and construct curb cut		
Bar. Severity:	1 Necessary	Cost Estimate:	\$2,500.00
Implementation Priority:	3	Facility Function:	
Implementation Phase:		Implementation Date:	
Official Responsible:			
Notes:	Two - way intersection corners B,C

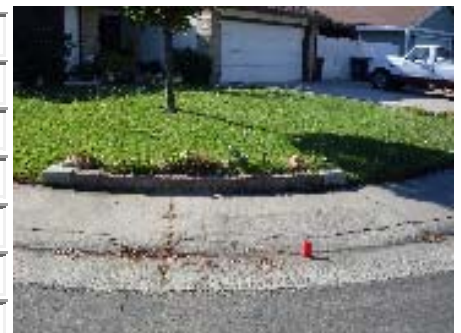
Field Date:	#####	Report Date:	10/12/2010	Barrier #:	486
Location:	Zenith Dr and Posten Wy - Corner C				
X Coordinate:	-121.31147				
Y Coordinate:	38.71056				
Barrier Area:	Curb Ramps				
Barrier Type:	No Curb Ramp - Depressed Exsiting Curb				
Code Ref:	CBC 1127B.5.1 and ADA/ABA 402.2

As Built Meas:	1	Quantity:	EACH
Description:	No compliant curb cut at corner (intersection)		
As Built Desc:	12.8% running slope at depressed area		
Solution:	Demolish existing and construct curb cut		
Bar. Severity:	1 Necessary	Cost Estimate:	\$2,500.00
Implementation Priority:	3	Facility Function:	
Implementation Phase:		Implementation Date:	
Official Responsible:			
Notes:	Two - way intersection corners B,C

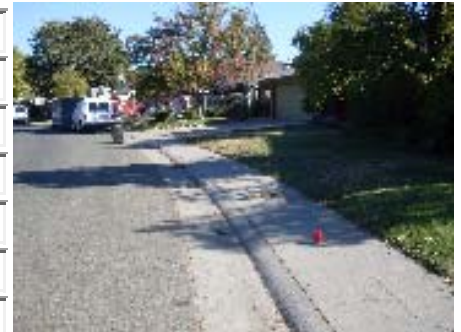
Field Date:	#####	Report Date:	10/12/2010	Barrier #:	487A
Location:	Zenith Dr - East				
X Coordinate:	-121.31136				
Y Coordinate:	38.71065				
Barrier Area:	Sidewalks				
Barrier Type:	Cross Slope - Existing (5.0% or more)				
Code Ref:	CBC 1133B.7.1.3 and ADA/ABA 403.3

As Built Meas:	276	Quantity:	LF
Description:	Cross slope exceeds 2.0% (5.0% or more)		
As Built Desc:	5.7% cross slope		
Solution:	Demolish existing and construct new route		
Bar. Severity:	1 Necessary	Cost Estimate:	\$34,500.00
Implementation Priority:	3	Facility Function:	
Implementation Phase:		Implementation Date:	
Official Responsible:			
Notes:

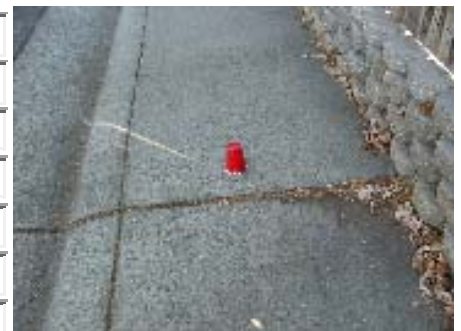
Field Date:	#####	Report Date:	10/12/2010	Barrier #:	487B
Location:	Zenith Dr - East				
X Coordinate:	-121.31122				
Y Coordinate:	38.71108				
Barrier Area:	Sidewalks				
Barrier Type:	Abrupt Change in Level - Tree Heaves				
Code Ref:	CBC 1133B.7.1 and ADA/ABA 303.3

As Built Meas:	4	Quantity:	LF
Description:	Change in level greater than 1/2"		
As Built Desc:	1" lip due to tree heaves		
Solution:	Grind or repair sidewalk to remove trip hazard		
Bar. Severity:	1 Necessary	Cost Estimate:	\$1,000.00
Implementation Priority:	3	Facility Function:	
Implementation Phase:		Implementation Date:	
Official Responsible:			
Notes:

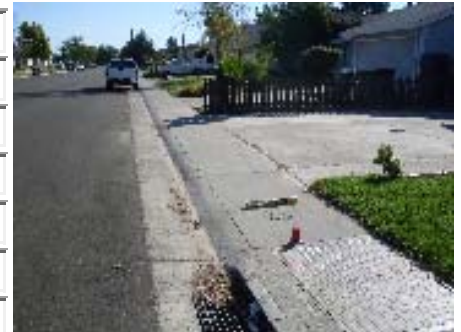
Field Date:	#####	Report Date:	10/12/2010	Barrier #:	488
Location:	Carmelwood Dr - South				
X Coordinate:	-121.31106				
Y Coordinate:	38.71155				
Barrier Area:	Sidewalks				
Barrier Type:	Cross Slope - Existing (4.1% to 4.9%)				
Code Ref:	CBC 1133B.7.1.3 and ADA/ABA 403.3

As Built Meas:	783	Quantity:	LF
Description:	Cross slope exceeds 2.0% (4.1% to 4.9%)		
As Built Desc:	4.9% cross slope		
Solution:	Demolish existing and construct new route		
Bar. Severity:	2 Recommended	Cost Estimate:	\$97,875.00
Implementation Priority:	4	Facility Function:	
Implementation Phase:		Implementation Date:	
Official Responsible:

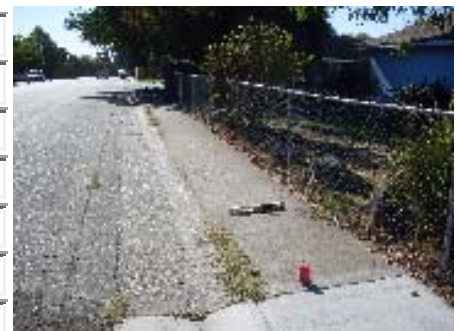
Field Date:	#####	Report Date:	10/12/2010	Barrier #:	489A
Location:	Lichen Dr - West				
X Coordinate:	-121.30825				
Y Coordinate:	38.71158				
Barrier Area:	Sidewalks				
Barrier Type:	Cross Slope - Existing (5.0% or more)				
Code Ref:	CBC 1133B.7.1.3 and ADA/ABA 403.3

As Built Meas:	118	Quantity:	LF
Description:	Cross slope exceeds 2.0% (5.0% or more)		
As Built Desc:	5.3% cross slope		
Solution:	Demolish existing and construct new route		
Bar. Severity:	1 Necessary	Cost Estimate:	\$14,750.00
Implementation Priority:	2	Facility Function:	
Implementation Phase:		Implementation Date:	
Official Responsible:

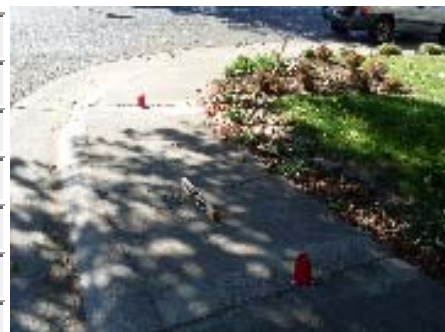
Barrier Type: Running Slope (Existing)

Code Ref: CBC 1133B.7.3 and ADA/ABA 403.3

As Built Meas: 12 Quantity: LF

Description: Running slope exceeds 5.0%

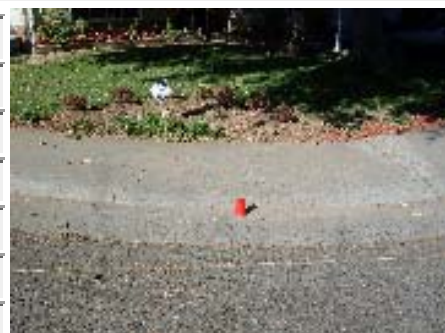
Barrier Type: No Curb Ramp - Depressed Existing Curb

Code Ref: CBC 1127B.5.1 and ADA/ABA 402.2

As Built Meas: 1 Quantity: EACH

Description: No compliant curb cut at corner (intersection)

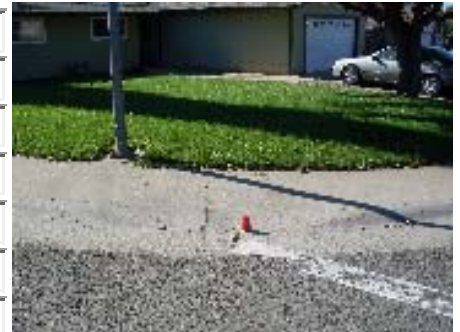
Field Date:	#####	Report Date:	10/12/2010	Barrier #:	491
Location:	Lichen Dr and Kaestner Ct - Corner D				
X Coordinate:	-121.30786				
Y Coordinate:	38.71112				
Barrier Area:	Curb Ramps				
Barrier Type:	No Curb Ramp - Depressed Exsiting Curb				
Code Ref:	CBC 1127B.5.1 and ADA/ABA 402.2

As Built Meas:	1	Quantity:	EACH
Description:	No compliant curb cut at corner (intersection)		
As Built Desc:	12.2% running slope at depressed area		
Solution:	Demolish existing and construct curb cut		
Bar. Severity:	1 Necessary	Cost Estimate:	\$2,500.00
Implementation Priority:	2	Facility Function:	
Implementation Phase:		Implementation Date:	
Official Responsible:			
Notes:	Two - way intersection corners A,D

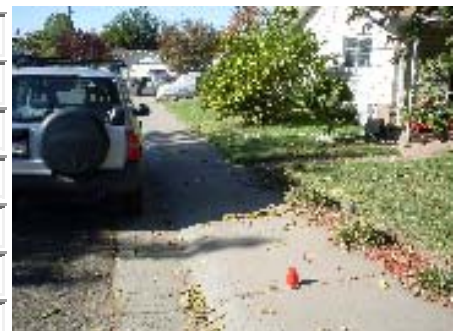
Field Date:	#####	Report Date:	10/12/2010	Barrier #:	492
Location:	Kaestner Ct - North				
X Coordinate:	-121.30797				
Y Coordinate:	38.71122				
Barrier Area:	Sidewalks				
Barrier Type:	Cross Slope - Existing (5.0% or more)				
Code Ref:	CBC 1133B.7.1.3 and ADA/ABA 403.3

As Built Meas:	220	Quantity:	LF
Description:	Cross slope exceeds 2.0% (5.0% or more)		
As Built Desc:	6.5% cross slope		
Solution:	Demolish existing and construct new route		
Bar. Severity:	1 Necessary	Cost Estimate:	\$27,500.00
Implementation Priority:	4	Facility Function:	
Implementation Phase:		Implementation Date:	
Official Responsible:			
Notes:

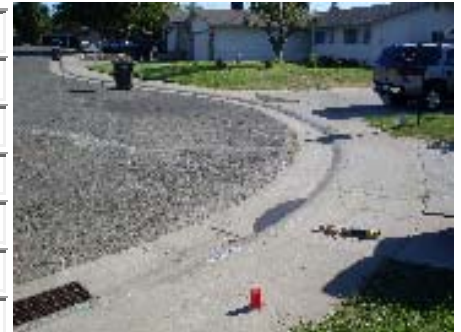
Field Date:	#####	Report Date:	10/12/2010	Barrier #:	493
Location:	Kaestner Ct - South				
X Coordinate:	-121.30845				
Y Coordinate:	38.71084				
Barrier Area:	Sidewalks				
Barrier Type:	Cross Slope - Existing (5.0% or more)				
Code Ref:	CBC 1133B.7.1.3 and ADA/ABA 403.3

As Built Meas:	194	Quantity:	LF
Description:	Cross slope exceeds 2.0% (5.0% or more)		
As Built Desc:	5.9% cross slope		
Solution:	Demolish existing and construct new route		
Bar. Severity:	1 Necessary	Cost Estimate:	\$24,250.00
Implementation Priority:	4	Facility Function:	
Implementation Phase:		Implementation Date:	
Official Responsible:			
Notes:

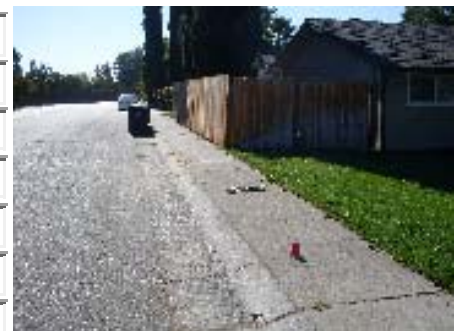
Field Date:	#####	Report Date:	10/12/2010	Barrier #:	494
Location:	Lichen Dr - West				
X Coordinate:	-121.30786				
Y Coordinate:	38.71112				
Barrier Area:	Sidewalks				
Barrier Type:	Cross Slope - Existing (4.1% to 4.9%)				
Code Ref:	CBC 1133B.7.1.3 and ADA/ABA 403.3

As Built Meas:	288	Quantity:	LF
Description:	Cross slope exceeds 2.0% (4.1% to 4.9%)		
As Built Desc:	4.5% cross slope		
Solution:	Demolish existing and construct new route		
Bar. Severity:	2 Recommended	Cost Estimate:	\$36,000.00
Implementation Priority:	2	Facility Function:	
Implementation Phase:		Implementation Date:	
Official Responsible:			
Notes:

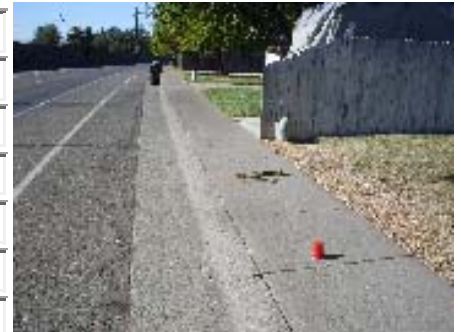
Field Date:	#####	Report Date:	10/12/2010	Barrier #:	495
Location:	Lichen Dr - North				
X Coordinate:	-121.30752				
Y Coordinate:	38.71017				
Barrier Area:	Sidewalks				
Barrier Type:	Cross Slope - Existing (4.1% to 4.9%)				
Code Ref:	CBC 1133B.7.1.3 and ADA/ABA 403.3

As Built Meas:	252	Quantity:	LF
Description:	Cross slope exceeds 2.0% (4.1% to 4.9%)		
As Built Desc:	4.4% cross slope		
Solution:	Demolish existing and construct new route		
Bar. Severity:	2 Recommended	Cost Estimate:	\$31,500.00
Implementation Priority:	2	Facility Function:	
Implementation Phase:		Implementation Date:	
Official Responsible:

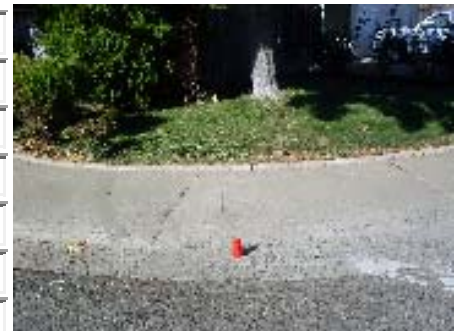
Field Date:	#####	Report Date:	10/12/2010	Barrier #:	496
Location:	Lichen Dr and Discus Ct - Corner A				
X Coordinate:	-121.30828				
Y Coordinate:	38.70958				
Barrier Area:	Curb Ramps				
Barrier Type:	No Curb Ramp - Depressed Existing Curb				
Code Ref:	CBC 1127B.5.1 and ADA/ABA 402.2

As Built Meas:	1	Quantity:	EACH
Description:	No compliant curb cut at corner (intersection)		
As Built Desc:	9.0% running slope at depressed area		
Solution:	Demolish existing and construct curb cut		
Bar. Severity:	1 Necessary	Cost Estimate:	\$2,500.00
Implementation Priority:	2	Facility Function:	
Implementation Phase:		Implementation Date:	
Official Responsible:
