DRAFT ADA TRANSITION PLAN UPDATE
NEIGHBORHOOD AREA 1 NORTHWEST
SEPTEMBER 20, 2011

CITY OF CITRUS HEIGHTS

The Northwest Neighborhood Association

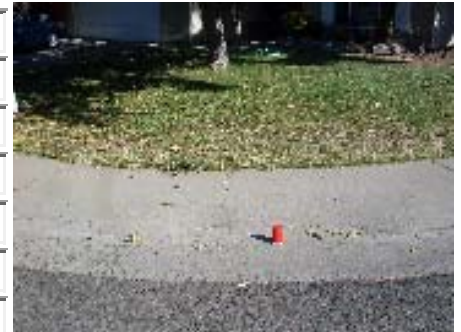
Field Date:	#####	Report Date:	10/12/2010	Barrier #:	497
Location:	Lichen Dr and Discus Ct - Corner B				
X Coordinate:	-121.30819				
Y Coordinate:	38.70966				
Barrier Area:	Curb Ramps				
Barrier Type:	No Curb Ramp - Depressed Exsiting Curb				
Code Ref:	CBC 1127B.5.1 and ADA/ABA 402.2

As Built Meas:	1	Quantity:	EACH
Description:	No compliant curb cut at corner (intersection)		
As Built Desc:	12.4% running slope at depressed area		
Solution:	Demolish existing and construct curb cut		
Bar. Severity:	1 Necessary	Cost Estimate:	\$2,500.00
Implementation Priority:	2	Facility Function:	
Implementation Phase:		Implementation Date:	
Official Responsible:			
Notes:	Two - way intersection corners A,B

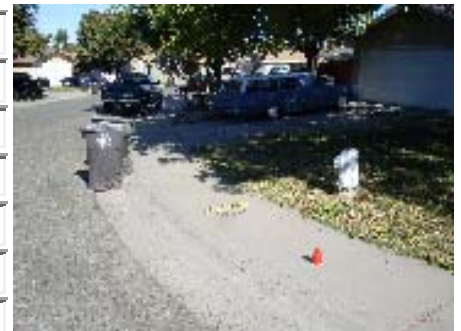
Field Date:	#####	Report Date:	10/12/2010	Barrier #:	498
Location:	Discus Ct - North				
X Coordinate:	-121.30823				
Y Coordinate:	38.70969				
Barrier Area:	Sidewalks				
Barrier Type:	Cross Slope - Existing (5.0% or more)				
Code Ref:	CBC 1133B.7.1.3 and ADA/ABA 403.3

As Built Meas:	266	Quantity:	LF
Description:	Cross slope exceeds 2.0% (5.0% or more)		
As Built Desc:	7.0% cross slope		
Solution:	Demolish existing and construct new route		
Bar. Severity:	1 Necessary	Cost Estimate:	\$33,250.00
Implementation Priority:	4	Facility Function:	
Implementation Phase:		Implementation Date:	
Official Responsible:			
Notes:

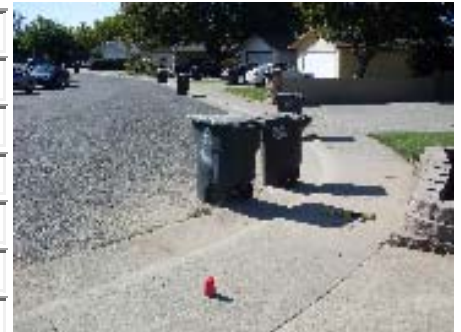
Field Date:	#####	Report Date:	10/12/2010	Barrier #:	499
Location:	Discus Ct - South				
X Coordinate:	-121.30846				
Y Coordinate:	38.71027				
Barrier Area:	Sidewalks				
Barrier Type:	Cross Slope - Existing (5.0% or more)				
Code Ref:	CBC 1133B.7.1.3 and ADA/ABA 403.3

As Built Meas:	279	Quantity:	LF
Description:	Cross slope exceeds 2.0% (5.0% or more)		
As Built Desc:	6.6% cross slope		
Solution:	Demolish existing and construct new route		
Bar. Severity:	1 Necessary	Cost Estimate:	\$34,875.00
Implementation Priority:	4	Facility Function:	
Implementation Phase:		Implementation Date:	
Official Responsible:

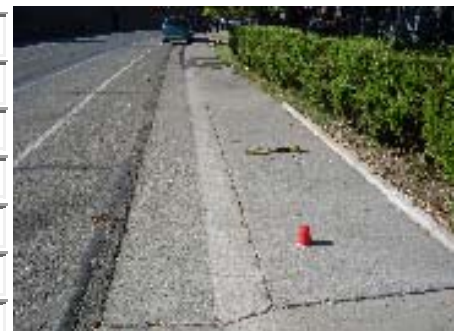
Field Date:	#####	Report Date:	10/12/2010	Barrier #:	500A
Location:	Lichen Dr - West				
X Coordinate:	-121.30831				
Y Coordinate:	38.70953				
Barrier Area:	Sidewalks				
Barrier Type:	Cross Slope - Existing (5.0% or more)				
Code Ref:	CBC 1133B.7.1.3 and ADA/ABA 403.3

As Built Meas:	204	Quantity:	LF
Description:	Cross slope exceeds 2.0% (5.0% or more)		
As Built Desc:	6.0% cross slope		
Solution:	Demolish existing and construct new route		
Bar. Severity:	1 Necessary	Cost Estimate:	\$25,500.00
Implementation Priority:	2	Facility Function:	
Implementation Phase:		Implementation Date:	
Official Responsible:

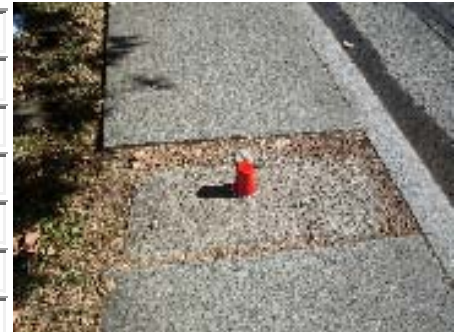
Field Date:	#####	Report Date:	10/12/2010	Barrier #:	500B
Location:	Lichen Dr - West				
X Coordinate:	-121.30852				
Y Coordinate:	38.70937				
Barrier Area:	Sidewalks				
Barrier Type:	Surface Condition - Damaged				
Code Ref:	CBC 1133B.7.1 and ADA/ABA 302.1

As Built Meas:	4	Quantity:	LF	
Description:	Surface is not firm and stable (cracked, broken or loose soil, etc.)			
As Built Desc:	Cracked concrete			
Solution:	Repair surface to make firm and stable			
Bar. Severity:	1 Necessary	Cost Estimate:	\$500.00	Status:
Implementation Priority:	2	Facility Function:		
Implementation Phase:		Implementation Date:		
Official Responsible:				
Notes:

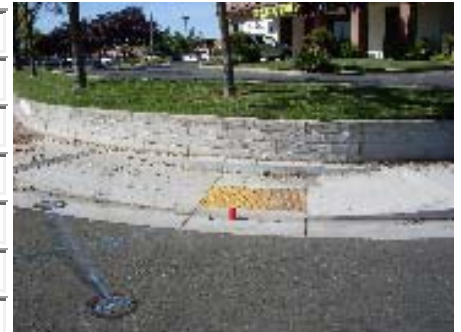
Barrier Type: 12" Grooves - New Construction

As Built Meas: 1 Quantity: EACH

Description: 12" grooves at top of curb ramp are not level (4.1% to 4.9%)

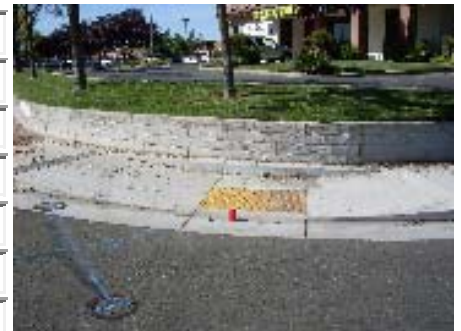
Barrier Type: Gutter Slope - New Construction

As Built Meas: 1 Quantity: SF

Description: Gutter slope exceeds 5.0% (5.9% - 6.5%)

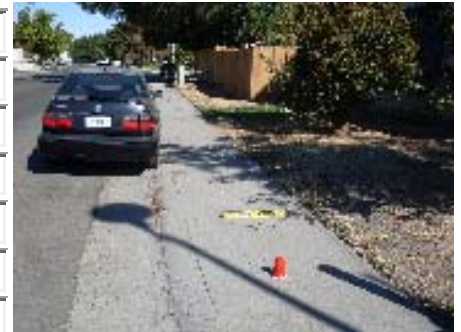
Field Date:	#####	Report Date:	10/12/2010	Barrier #:	503A
Location:	Brimstone Dr - East				
X Coordinate:	-121.31131				
Y Coordinate:	38.70876				
Barrier Area:	Sidewalks				
Barrier Type:	Cross Slope - Existing (4.1% to 4.9%)				
Code Ref:	CBC 1133B.7.1.3 and ADA/ABA 403.3

As Built Meas:	179	Quantity:	LF		
Description:	Cross slope exceeds 2.0% (4.1% to 4.9%)				
As Built Desc:	4.7% cross slope				
Solution:	Demolish existing and construct new route				
Bar. Severity:	2 Recommended	Cost Estimate:	\$22,375.00	Status:	
Implementation Priority:	4	Facility Function:			
Implementation Phase:		Implementation Date:			
Official Responsible:					
Notes:

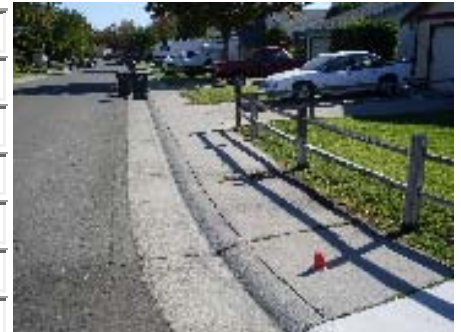
Field Date:	#####	Report Date:	10/12/2010	Barrier #:	504A
Location:	Branchwater Wy - South				
X Coordinate:	-121.31131				
Y Coordinate:	38.70927				
Barrier Area:	Sidewalks				
Barrier Type:	Cross Slope - Existing (4.1% to 4.9%)				
Code Ref:	CBC 1133B.7.1.3 and ADA/ABA 403.3

As Built Meas:	616	Quantity:	LF
Description:	Cross slope exceeds 2.0% (4.1% to 4.9%)		
As Built Desc:	4.4% cross slope		
Solution:	Demolish existing and construct new route		
Bar. Severity:	2 Recommended	Cost Estimate:	\$77,000.00
Implementation Priority:	4	Facility Function:	
Implementation Phase:		Implementation Date:	
Official Responsible:			
Notes:

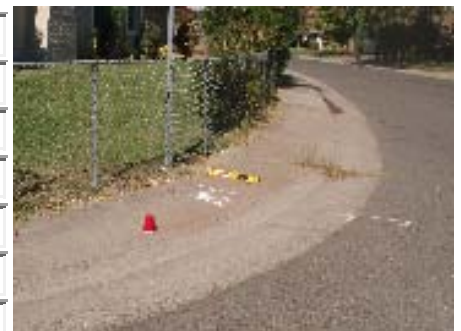
Field Date:	#####	Report Date:	10/15/2010	Barrier #:	813
Location:	Parkvale Wy - West				
X Coordinate:	-121.32074				
Y Coordinate:	38.69919				
Barrier Area:	Sidewalks				
Barrier Type:	Cross Slope - Existing (5.0% or more)				
Code Ref:	CBC 1133B.7.1.3 and ADA/ABA 403.3

As Built Meas:	212	Quantity:	LF
Description:	Cross slope exceeds 2.0% (5.0% or more)		
As Built Desc:	5.9% cross slope		
Solution:	Demolish existing and construct new route		
Bar. Severity:	1 Necessary	Cost Estimate:	\$26,500.00
Implementation Priority:	4	Facility Function:	
Implementation Phase:		Implementation Date:	
Official Responsible:			
Notes:

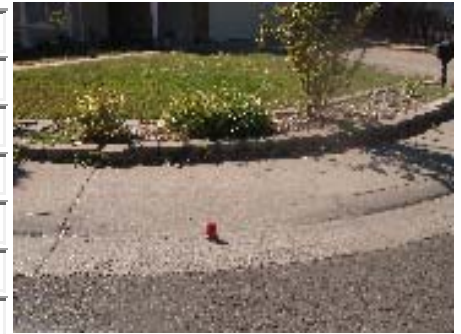
Field Date:	#####	Report Date:	10/15/2010	Barrier #:	814
Location:	Parkvale Wy - West				
X Coordinate:	-121.32113				
Y Coordinate:	38.69973				
Barrier Area:	Sidewalks				
Barrier Type:	Elbow in Sidewalk - Cross Slope (5.0% or more)				
Code Ref:	CBC 1133B.7.1.3 and ADA/ABA 403.3

As Built Meas:	6	Quantity:	LF
Description:	Cross slope at elbow exceeds 2.0% (5.0% or more)		
As Built Desc:	16.1% cross slope		
Solution:	Demolish existing and construct new sidewalk without curb ramp		
Bar. Severity:	1 Necessary	Cost Estimate:	\$750.00
Implementation Priority:	4	Facility Function:	
Implementation Phase:		Implementation Date:	
Official Responsible:			
Notes:

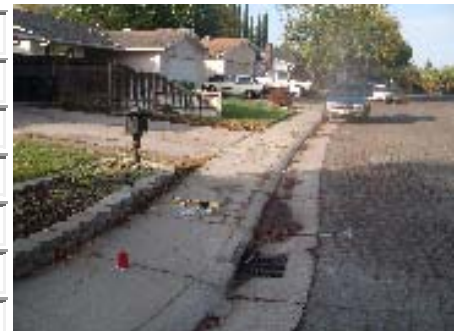
Field Date:	#####	Report Date:	10/18/2010	Barrier #:	815A
Location:	Parkvale Wy - South				
X Coordinate:	-121.32129				
Y Coordinate:	38.69963				
Barrier Area:	Sidewalks				
Barrier Type:	Cross Slope - Existing (5.0% or more)				
Code Ref:	CBC 1133B.7.1.3 and ADA/ABA 403.3

As Built Meas:	624	Quantity:	LF
Description:	Cross slope exceeds 2.0% (5.0% or more)		
As Built Desc:	5.7% cross slope		
Solution:	Demolish existing and construct new route		
Bar. Severity:	1 Necessary	Cost Estimate:	\$78,000.00
Implementation Priority:	4	Facility Function:	
Implementation Phase:		Implementation Date:	
Official Responsible:			
Notes:

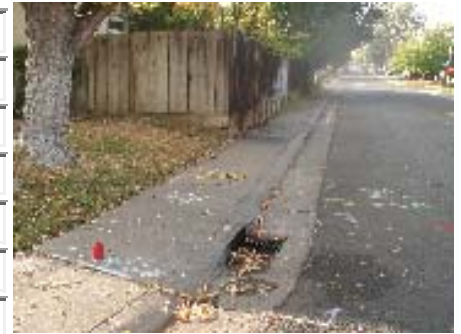
Field Date:	#####	Report Date:	10/18/2010	Barrier #:	817A
Location:	Parkvale Wy - East				
X Coordinate:	-121.32339				
Y Coordinate:	38.69946				
Barrier Area:	Sidewalks				
Barrier Type:	Cross Slope - Existing (5.0% or more)				
Code Ref:	CBC 1133B.7.1.3 and ADA/ABA 403.3

As Built Meas:	173	Quantity:	LF
Description:	Cross slope exceeds 2.0% (5.0% or more)		
As Built Desc:	5.8% cross slope		
Solution:	Demolish existing and construct new route		
Bar. Severity:	1 Necessary	Cost Estimate:	\$21,625.00
Implementation Priority:	4	Facility Function:	
Implementation Phase:		Implementation Date:	
Official Responsible:			
Notes:

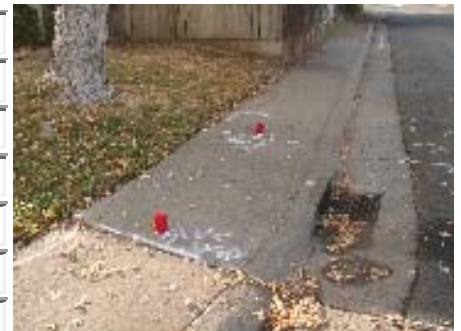
Field Date:	#####	Report Date:	10/18/2010	Barrier #:	817B
Location:	Parkvale Wy - East				
X Coordinate:	-121.3234				
Y Coordinate:	38.69947				
Barrier Area:	Sidewalks				
Barrier Type:	Abrupt Change in Level - Tree Heaves				
Code Ref:	CBC 1133B.7.1 and ADA/ABA 303.3

As Built Meas:	8	Quantity:	LF
Description:	Change in level greater than 1/2"		
As Built Desc:	1/2" lip due to tree heaves		
Solution:	Grind or repair sidewalk to remove trip hazard		
Bar. Severity:	1 Necessary	Cost Estimate:	\$2,000.00
Implementation Priority:	4	Facility Function:	
Implementation Phase:		Implementation Date:	
Official Responsible:			
Notes:

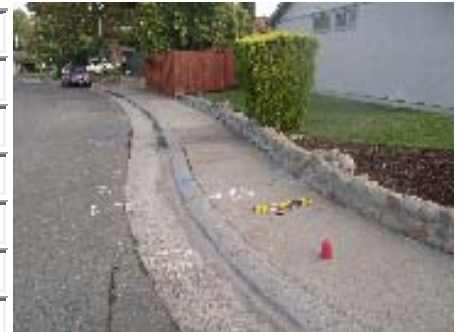
Field Date:	#####	Report Date:	10/18/2010	Barrier #:	818
Location:	Parkvale Wy - East				
X Coordinate:	-121.32065				
Y Coordinate:	38.69911				
Barrier Area:	Sidewalks				
Barrier Type:	Cross Slope - Existing (5.0% or more)				
Code Ref:	CBC 1133B.7.1.3 and ADA/ABA 403.3

As Built Meas:	248	Quantity:	LF
Description:	Cross slope exceeds 2.0% (5.0% or more)		
As Built Desc:	6.3% cross slope		
Solution:	Demolish existing and construct new route		
Bar. Severity:	1 Necessary	Cost Estimate:	\$31,000.00
Implementation Priority:	4	Facility Function:	
Implementation Phase:		Implementation Date:	
Official Responsible:			
Notes:

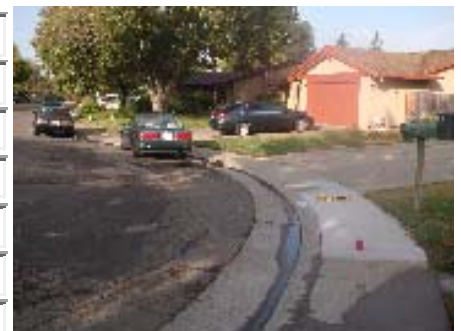
Field Date:	#####	Report Date:	10/18/2010	Barrier #:	819A
Location:	Parkvale Wy - North				
X Coordinate:	-121.32117				
Y Coordinate:	38.69974				
Barrier Area:	Sidewalks				
Barrier Type:	Cross Slope - Existing (5.0% or more)				
Code Ref:	CBC 1133B.7.1.3 and ADA/ABA 403.3

As Built Meas:	362	Quantity:	LF
Description:	Cross slope exceeds 2.0% (5.0% or more)		
As Built Desc:	6.2% cross slope		
Solution:	Demolish existing and construct new route		
Bar. Severity:	1 Necessary	Cost Estimate:	\$45,250.00
Implementation Priority:	4	Facility Function:	
Implementation Phase:		Implementation Date:	
Official Responsible:			
Notes:

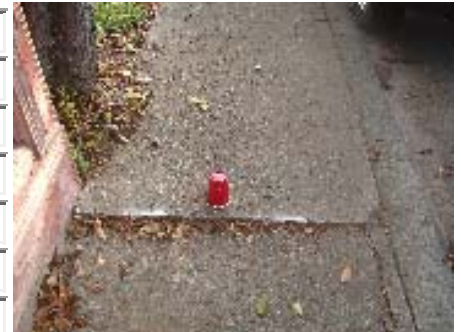
Field Date:	#####	Report Date:	10/18/2010	Barrier #:	819B
Location:	Parkvale Wy - North				
X Coordinate:	-121.32183				
Y Coordinate:	38.69967				
Barrier Area:	Sidewalks				
Barrier Type:	Abrupt Change in Level - > 1/2"				
Code Ref:	CBC 1133B.7.1 and ADA/ABA 303.3

As Built Meas:	4	Quantity:	LF
Description:	Change in level greater than 1/2"		
As Built Desc:	1/2" lip in sidewalk surface		
Solution:	Grind or repair sidewalk to remove trip hazard		
Bar. Severity:	1 Necessary	Cost Estimate:	\$1,000.00
Implementation Priority:	4	Facility Function:	
Implementation Phase:		Implementation Date:	
Official Responsible:			
Notes:

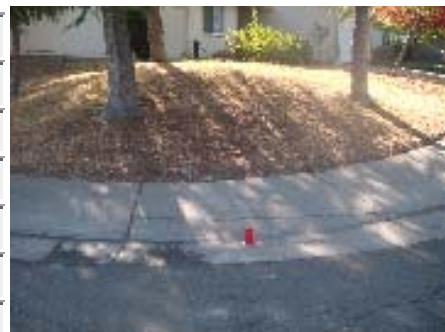
Barrier Type: No Curb Ramp - Depressed Exsiting Curb

As Built Meas: 1 Quantity: EACH

Description: No compliant curb cut at corner (intersection)

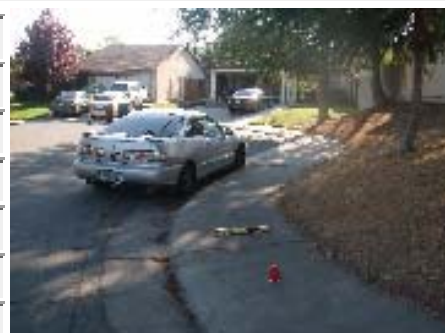
Barrier Type: Cross Slope - Existing (4.1% to 4.9%)

As Built Meas: 117 Quantity: LF

Description: Cross slope exceeds 2.0% (4.1% to 4.9%)

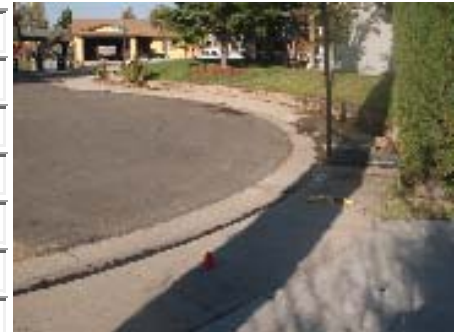
Field Date:	#####	Report Date:	10/19/2010	Barrier #:	983
Location:	Parkvale Ct - North				
X Coordinate:	-121.3231				
Y Coordinate:	38.69632				
Barrier Area:	Sidewalks				
Barrier Type:	Cross Slope - Existing (4.1% to 4.9%)				
Code Ref:	CBC 1133B.7.1.3 and ADA/ABA 403.3

As Built Meas:	112	Quantity:	LF
Description:	Cross slope exceeds 2.0% (4.1% to 4.9%)		
As Built Desc:	4.5% cross slope		
Solution:	Demolish existing and construct new route		
Bar. Severity:	2 Recommended	Cost Estimate:	\$14,000.00
Implementation Priority:	4	Facility Function:	
Implementation Phase:		Implementation Date:	
Official Responsible:

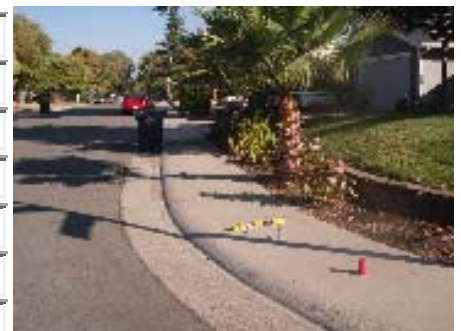
Field Date:	#####	Report Date:	10/19/2010	Barrier #:	984A
Location:	Parkvale Wy - East				
X Coordinate:	-121.32346				
Y Coordinate:	38.69642				
Barrier Area:	Sidewalks				
Barrier Type:	Cross Slope - Existing (3.1% to 4.0%)				
Code Ref:	CBC 1133B.7.1.3 and ADA/ABA 403.3

As Built Meas:	171	Quantity:	LF
Description:	Cross slope exceeds 2.0% (3.1% to 4.0%)		
As Built Desc:	3.6% cross slope		
Solution:	Demolish existing and construct new route		
Bar. Severity:	3 Hindrance	Cost Estimate:	\$21,375.00
Implementation Priority:	4	Facility Function:	
Implementation Phase:		Implementation Date:	
Official Responsible:

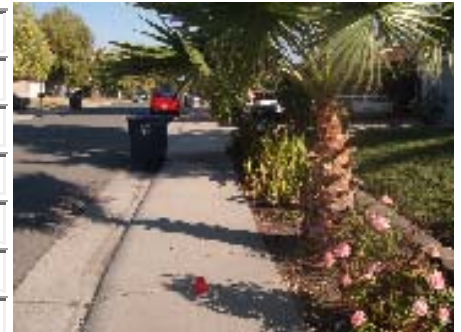
Barrier Type: Protruding Hazard

As Built Meas: 1 Quantity: JOB

Description: Protruding object in route of travel between 27" and 80" high

As Built Desc: 60" protruding hazard at tree branches

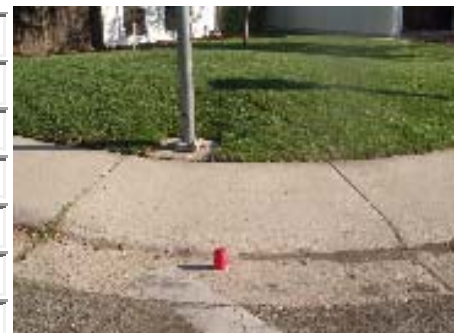
Barrier Type: No Curb Ramp - Depressed Exsiting Curb

As Built Meas: 1 Quantity: EACH

Description: No compliant curb cut at corner (intersection)

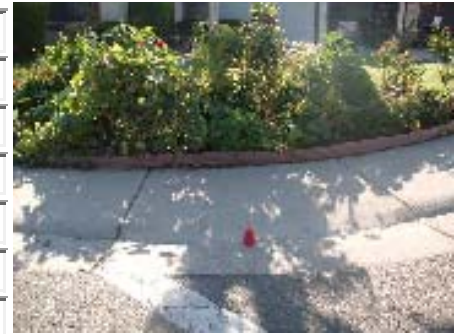
Field Date:	#####	Report Date:	10/19/2010	Barrier #:	986
Location:	Parkway Wy and Shawnda Ct - Corner C				
X Coordinate:	-121.32343				
Y Coordinate:	38.69693				
Barrier Area:	Curb Ramps				
Barrier Type:	No Curb Ramp - Depressed Exsiting Curb				
Code Ref:	CBC 1127B.5.1 and ADA/ABA 402.2

As Built Meas:	1	Quantity:	EACH
Description:	No compliant curb cut at corner (intersection)		
As Built Desc:	12.9% running slope at depressed area		
Solution:	Demolish existing and construct curb cut		
Bar. Severity:	1 Necessary	Cost Estimate:	\$2,500.00
Implementation Priority:	4	Facility Function:	
Implementation Phase:		Implementation Date:	
Official Responsible:			
Notes:	Two - way intersection corners B,C

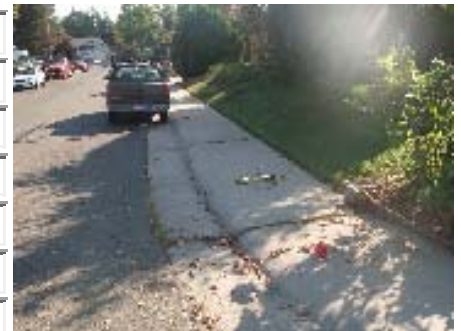
Field Date:	#####	Report Date:	10/19/2010	Barrier #:	987
Location:	Shawnda Ct - South				
X Coordinate:	-121.32338				
Y Coordinate:	38.69693				
Barrier Area:	Sidewalks				
Barrier Type:	Cross Slope - Existing (3.1% to 4.0%)				
Code Ref:	CBC 1133B.7.1.3 and ADA/ABA 403.3

As Built Meas:	130	Quantity:	LF
Description:	Cross slope exceeds 2.0% (3.1% to 4.0%)		
As Built Desc:	3.6% cross slope		
Solution:	Demolish existing and construct new route		
Bar. Severity:	3 Hindrance	Cost Estimate:	\$16,250.00
Implementation Priority:	4	Facility Function:	
Implementation Phase:		Implementation Date:	
Official Responsible:			
Notes:

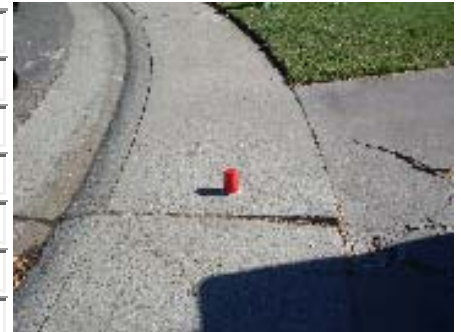
Field Date:	#####	Report Date:	10/12/2010	Barrier #:	504B
Location:	Branchwater Wy - South				
X Coordinate:	-121.30927				
Y Coordinate:	38.70962				
Barrier Area:	Sidewalks				
Barrier Type:	Abrupt Change in Level - > 1/2"				
Code Ref:	CBC 1133B.7.1 and ADA/ABA 303.3

As Built Meas:	4	Quantity:	LF
Description:	Change in level greater than 1/2"		
As Built Desc:	1" lip in sidewalk surface		
Solution:	Grind or repair sidewalk to remove trip hazard		
Bar. Severity:	1 Necessary	Cost Estimate:	\$1,000.00
Implementation Priority:	4	Facility Function:	
Implementation Phase:		Implementation Date:	
Official Responsible:			
Notes:

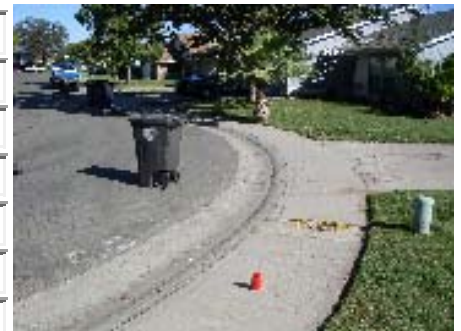
Field Date:	#####	Report Date:	10/12/2010	Barrier #:	505
Location:	Branchwater Wy - East				
X Coordinate:	-121.30921				
Y Coordinate:	38.70966				
Barrier Area:	Sidewalks				
Barrier Type:	Cross Slope - Existing (5.0% or more)				
Code Ref:	CBC 1133B.7.1.3 and ADA/ABA 403.3

As Built Meas:	486	Quantity:	LF
Description:	Cross slope exceeds 2.0% (5.0% or more)		
As Built Desc:	5.8% cross slope		
Solution:	Demolish existing and construct new route		
Bar. Severity:	1 Necessary	Cost Estimate:	\$60,750.00
Implementation Priority:	4	Facility Function:	
Implementation Phase:		Implementation Date:	
Official Responsible:			
Notes:

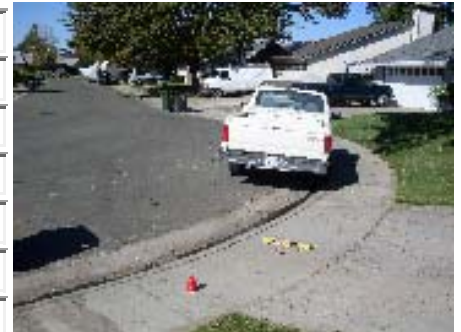
Field Date:	#####	Report Date:	10/12/2010	Barrier #:	506
Location:	Cranberry Ct - North				
X Coordinate:	-121.30923				
Y Coordinate:	38.71092				
Barrier Area:	Sidewalks				
Barrier Type:	Cross Slope - Existing (3.1% to 4.0%)				
Code Ref:	CBC 1133B.7.1.3 and ADA/ABA 403.3

As Built Meas:	394	Quantity:	LF
Description:	Cross slope exceeds 2.0% (3.1% to 4.0%)		
As Built Desc:	3.7% cross slope		
Solution:	Demolish existing and construct new route		
Bar. Severity:	3 Hindrance	Cost Estimate:	\$49,250.00
Implementation Priority:	4	Facility Function:	
Implementation Phase:		Implementation Date:	
Official Responsible:			
Notes:

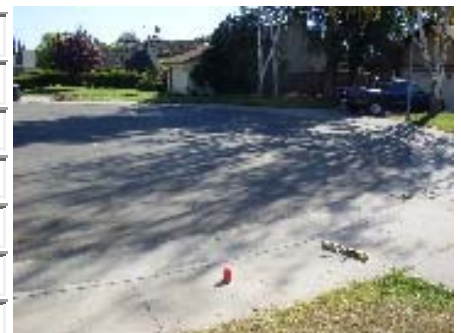
Field Date:	#####	Report Date:	10/12/2010	Barrier #:	507A
Location:	Cranberry Ct - South				
X Coordinate:	-121.31045				
Y Coordinate:	38.71080				
Barrier Area:	Sidewalks				
Barrier Type:	Cross Slope - Existing (5.0% or more)				
Code Ref:	CBC 1133B.7.1.3 and ADA/ABA 403.3

As Built Meas:	351	Quantity:	LF
Description:	Cross slope exceeds 2.0% (5.0% or more)		
As Built Desc:	5.0% cross slope		
Solution:	Demolish existing and construct new route		
Bar. Severity:	1 Necessary	Cost Estimate:	\$43,875.00
Implementation Priority:	4	Facility Function:	
Implementation Phase:		Implementation Date:	
Official Responsible:			
Notes:

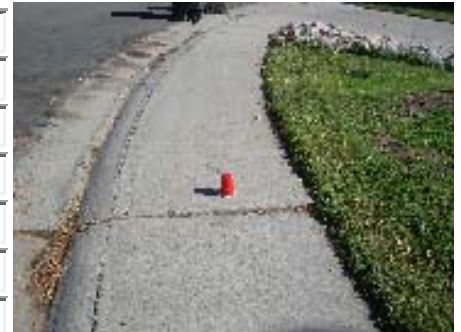
Field Date:	#####	Report Date:	10/12/2010	Barrier #:	507B
Location:	Cranberry Ct - South				
X Coordinate:	-121.31021				
Y Coordinate:	38.71082				
Barrier Area:	Sidewalks				
Barrier Type:	Abrupt Change in Level - Tree Heaves				
Code Ref:	CBC 1133B.7.1 and ADA/ABA 303.3

As Built Meas:	4	Quantity:	LF		
Description:	Change in level greater than 1/2"				
As Built Desc:	1" lip due to tree heaves				
Solution:	Grind or repair sidewalk to remove trip hazard				
Bar. Severity:	1 Necessary	Cost Estimate:	\$1,000.00	Status:	
Implementation Priority:	4	Facility Function:			
Implementation Phase:		Implementation Date:			
Official Responsible:					
Notes:

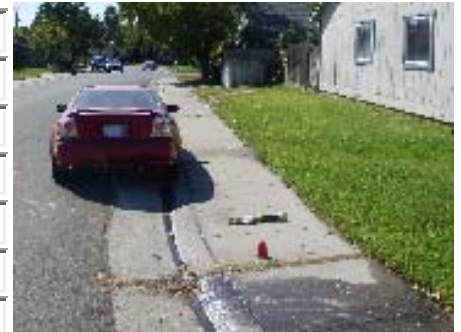
Field Date:	#####	Report Date:	10/12/2010	Barrier #:	508
Location:	Branchwater Wy - West				
X Coordinate:	-121.30933				
Y Coordinate:	38.71078				
Barrier Area:	Sidewalks				
Barrier Type:	Cross Slope - Existing (4.1% to 4.9%)				
Code Ref:	CBC 1133B.7.1.3 and ADA/ABA 403.3

As Built Meas:	197	Quantity:	LF
Description:	Cross slope exceeds 2.0% (4.1% to 4.9%)		
As Built Desc:	4.1% cross slope		
Solution:	Demolish existing and construct new route		
Bar. Severity:	2 Recommended	Cost Estimate:	\$24,625.00
Implementation Priority:	4	Facility Function:	
Implementation Phase:		Implementation Date:	
Official Responsible:

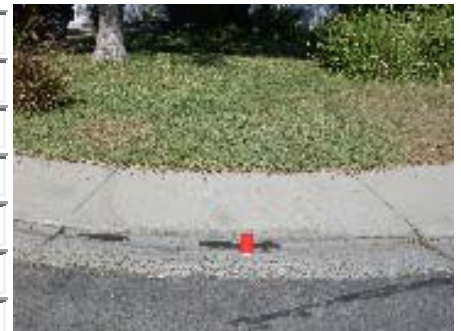
Field Date:	#####	Report Date:	10/12/2010	Barrier #:	509
Location:	Branchwater Wy and Posten Wy - Corner A				
X Coordinate:	-121.30936				
Y Coordinate:	38.71029				
Barrier Area:	Curb Ramps				
Barrier Type:	No Curb Ramp - Depressed Existing Curb				
Code Ref:	CBC 1127B.5.1 and ADA/ABA 402.2

As Built Meas:	1	Quantity:	EACH
Description:	No compliant curb cut at corner (intersection)		
As Built Desc:	9.0% running slope at depressed area		
Solution:	Demolish existing and construct curb cut		
Bar. Severity:	1 Necessary	Cost Estimate:	\$2,500.00
Implementation Priority:	4	Facility Function:	
Implementation Phase:		Implementation Date:	
Official Responsible:

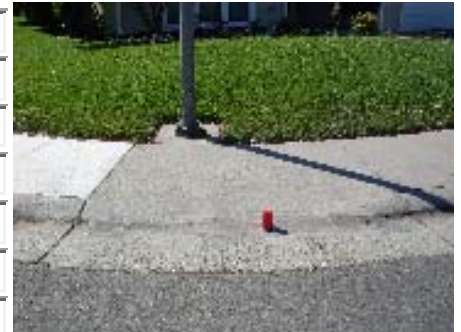
Field Date:	#####	Report Date:	10/12/2010	Barrier #:	510
Location:	Branchwater Wy and Posten Wy - Corner D				
X Coordinate:	-121.30941				
Y Coordinate:	38.71022				
Barrier Area:	Curb Ramps				
Barrier Type:	No Curb Ramp - Depressed Exsiting Curb				
Code Ref:	CBC 1127B.5.1 and ADA/ABA 402.2

As Built Meas:	1	Quantity:	EACH
Description:	No compliant curb cut at corner (intersection)		
As Built Desc:	12.1% running slope at depressed area		
Solution:	Demolish existing and construct curb cut		
Bar. Severity:	1 Necessary	Cost Estimate:	\$2,500.00
Implementation Priority:	4	Facility Function:	
Implementation Phase:		Implementation Date:	
Official Responsible:			
Notes:	Two - way intersection corners A,D

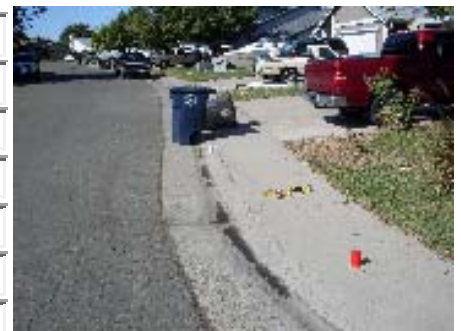
Field Date:	#####	Report Date:	10/12/2010	Barrier #:	511
Location:	Posten Wy - North				
X Coordinate:	-121.30940				
Y Coordinate:	38.71027				
Barrier Area:	Sidewalks				
Barrier Type:	Cross Slope - Existing (4.1% to 4.9%)				
Code Ref:	CBC 1133B.7.1.3 and ADA/ABA 403.3

As Built Meas:	400	Quantity:	LF
Description:	Cross slope exceeds 2.0% (4.1% to 4.9%)		
As Built Desc:	4.7% cross slope		
Solution:	Demolish existing and construct new route		
Bar. Severity:	2 Recommended	Cost Estimate:	\$50,000.00
Implementation Priority:	4	Facility Function:	
Implementation Phase:		Implementation Date:	
Official Responsible:			
Notes:

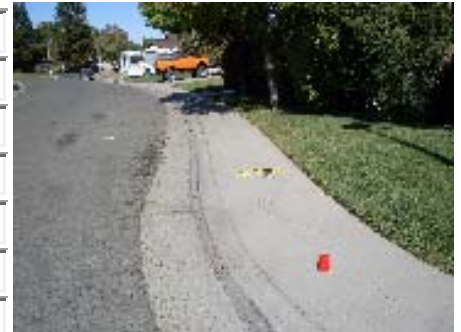
Field Date:	#####	Report Date:	10/12/2010	Barrier #:	512
Location:	Posten Wy - North				
X Coordinate:	-121.31078				
Y Coordinate:	38.71011				
Barrier Area:	Sidewalks				
Barrier Type:	Cross Slope - Existing (4.1% to 4.9%)				
Code Ref:	CBC 1133B.7.1.3 and ADA/ABA 403.3

As Built Meas:	265	Quantity:	LF
Description:	Cross slope exceeds 2.0% (4.1% to 4.9%)		
As Built Desc:	4.5% cross slope		
Solution:	Demolish existing and construct new route		
Bar. Severity:	2 Recommended	Cost Estimate:	\$33,125.00
Implementation Priority:	4	Facility Function:	
Implementation Phase:		Implementation Date:	
Official Responsible:

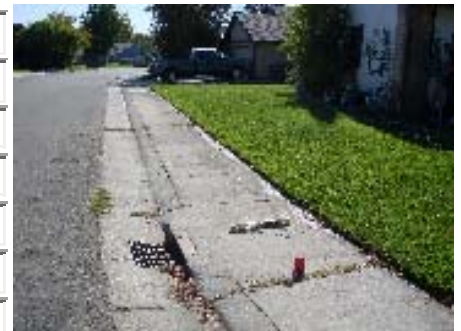
Field Date:	#####	Report Date:	10/12/2010	Barrier #:	513
Location:	Posten Wy - South				
X Coordinate:	-121.31141				
Y Coordinate:	38.71052				
Barrier Area:	Sidewalks				
Barrier Type:	Cross Slope - Existing (4.1% to 4.9%)				
Code Ref:	CBC 1133B.7.1.3 and ADA/ABA 403.3

As Built Meas:	295	Quantity:	LF
Description:	Cross slope exceeds 2.0% (4.1% to 4.9%)		
As Built Desc:	4.5% cross slope		
Solution:	Demolish existing and construct new route		
Bar. Severity:	2 Recommended	Cost Estimate:	\$36,875.00
Implementation Priority:	4	Facility Function:	
Implementation Phase:		Implementation Date:	
Official Responsible:

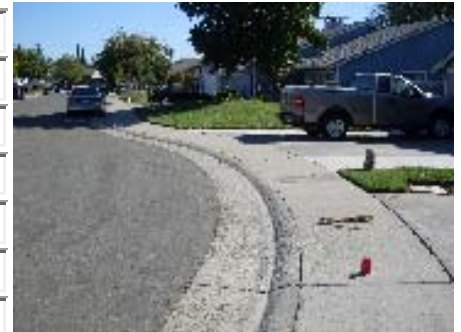
Field Date:	#####	Report Date:	10/12/2010	Barrier #:	514
Location:	Posten Wy - South				
X Coordinate:	-121.31078				
Y Coordinate:	38.71001				
Barrier Area:	Sidewalks				
Barrier Type:	Cross Slope - Existing (5.0% or more)				
Code Ref:	CBC 1133B.7.1.3 and ADA/ABA 403.3

As Built Meas:	412	Quantity:	LF
Description:	Cross slope exceeds 2.0% (5.0% or more)		
As Built Desc:	5.5% cross slope		
Solution:	Demolish existing and construct new route		
Bar. Severity:	1 Necessary	Cost Estimate:	\$51,500.00
Implementation Priority:	4	Facility Function:	
Implementation Phase:		Implementation Date:	
Official Responsible:			
Notes:

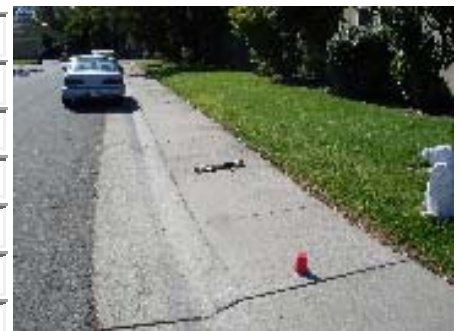
Field Date:	#####	Report Date:	10/12/2010	Barrier #:	515
Location:	Branchwater Wy - West				
X Coordinate:	-121.30934				
Y Coordinate:	38.71016				
Barrier Area:	Sidewalks				
Barrier Type:	Cross Slope - Existing (4.1% to 4.9%)				
Code Ref:	CBC 1133B.7.1.3 and ADA/ABA 403.3

As Built Meas:	162	Quantity:	LF
Description:	Cross slope exceeds 2.0% (4.1% to 4.9%)		
As Built Desc:	4.2% cross slope		
Solution:	Demolish existing and construct new route		
Bar. Severity:	2 Recommended	Cost Estimate:	\$20,250.00
Implementation Priority:	4	Facility Function:	
Implementation Phase:		Implementation Date:	
Official Responsible:			
Notes:

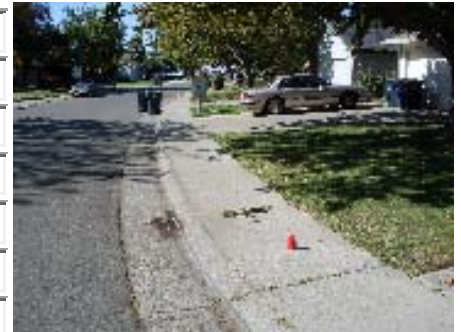
Field Date:	#####	Report Date:	10/12/2010	Barrier #:	516
Location:	Branchwater Wy - North				
X Coordinate:	-121.30936				
Y Coordinate:	38.70971				
Barrier Area:	Sidewalks				
Barrier Type:	Cross Slope - Existing (4.1% to 4.9%)				
Code Ref:	CBC 1133B.7.1.3 and ADA/ABA 403.3

As Built Meas:	599	Quantity:	LF
Description:	Cross slope exceeds 2.0% (4.1% to 4.9%)		
As Built Desc:	4.9% cross slope		
Solution:	Demolish existing and construct new route		
Bar. Severity:	2 Recommended	Cost Estimate:	\$74,875.00
Implementation Priority:	4	Facility Function:	
Implementation Phase:		Implementation Date:	
Official Responsible:

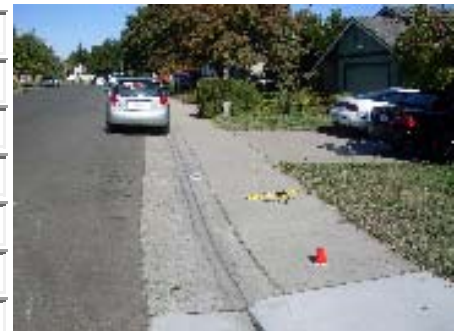
Field Date:	#####	Report Date:	10/12/2010	Barrier #:	517
Location:	Brimstone Dr - East				
X Coordinate:	-121.31142				
Y Coordinate:	38.70939				
Barrier Area:	Sidewalks				
Barrier Type:	Cross Slope - Existing (4.1% to 4.9%)				
Code Ref:	CBC 1133B.7.1.3 and ADA/ABA 403.3

As Built Meas:	359	Quantity:	LF
Description:	Cross slope exceeds 2.0% (4.1% to 4.9%)		
As Built Desc:	4.2% cross slope		
Solution:	Demolish existing and construct new route		
Bar. Severity:	2 Recommended	Cost Estimate:	\$44,875.00
Implementation Priority:	4	Facility Function:	
Implementation Phase:		Implementation Date:	
Official Responsible:

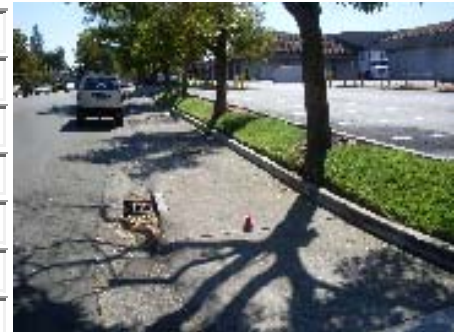
Field Date:	#####	Report Date:	10/12/2010	Barrier #:	518
Location:	Brimstone Dr - West				
X Coordinate:	-121.31189				
Y Coordinate:	38.71019				
Barrier Area:	Sidewalks				
Barrier Type:	Cross Slope - Existing (5.0% or more)				
Code Ref:	CBC 1133B.7.1.3 and ADA/ABA 403.3

As Built Meas:	116	Quantity:	LF
Description:	Cross slope exceeds 2.0% (5.0% or more)		
As Built Desc:	5.1% cross slope		
Solution:	Demolish existing and construct new route		
Bar. Severity:	1 Necessary	Cost Estimate:	\$14,500.00
Implementation Priority:	4	Facility Function:	
Implementation Phase:		Implementation Date:	
Official Responsible:

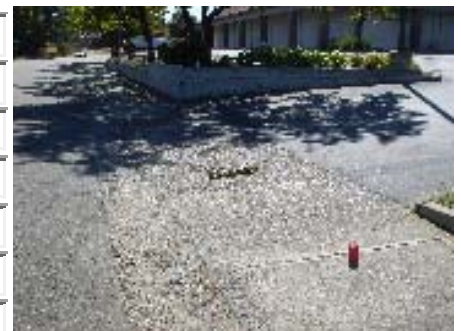
Field Date:	#####	Report Date:	10/12/2010	Barrier #:	519
Location:	Brimstone Dr - West				
X Coordinate:	-121.31184				
Y Coordinate:	38.70994				
Barrier Area:	Sidewalks				
Barrier Type:	Driveway - Existing (5.0% or more)				
Code Ref:	CBC 1133B.7.1.3 and ADA/ABA 403.3

As Built Meas:	38	Quantity:	LF
Description:	Driveway cross slope exceeds 2.0% (5.0% or more)		
As Built Desc:	7.9% cross slope		
Solution:	Provide min. 48" wide level walkway through driveway		
Bar. Severity:	4 Low Severity	Cost Estimate:	\$4,750.00
Implementation Priority:	4	Facility Function:	
Implementation Phase:		Implementation Date:	
Official Responsible:

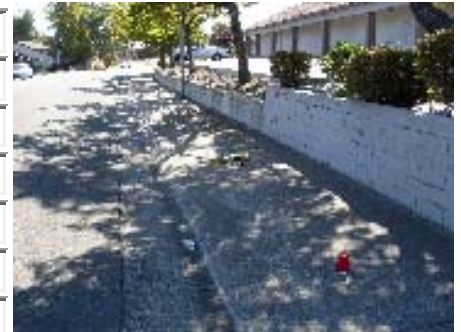
Field Date:	#####	Report Date:	10/12/2010	Barrier #:	520
Location:	Brimstone Dr - West				
X Coordinate:	-121.31179				
Y Coordinate:	38.70985				
Barrier Area:	Sidewalks				
Barrier Type:	Cross Slope - Existing (4.1% to 4.9%)				
Code Ref:	CBC 1133B.7.1.3 and ADA/ABA 403.3

As Built Meas:	213	Quantity:	LF		
Description:	Cross slope exceeds 2.0% (4.1% to 4.9%)				
As Built Desc:	4.7% cross slope				
Solution:	Demolish existing and construct new route				
Bar. Severity:	2 Recommended	Cost Estimate:	\$26,625.00	Status:	
Implementation Priority:	4	Facility Function:			
Implementation Phase:		Implementation Date:			
Official Responsible:					
Notes:

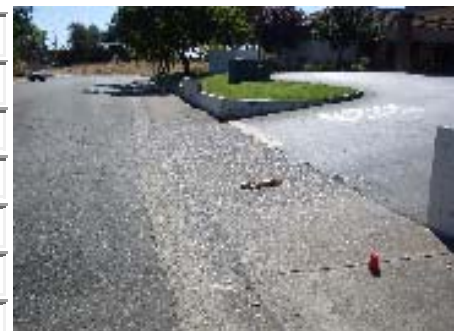
Field Date:	#####	Report Date:	10/12/2010	Barrier #:	521
Location:	Brimstone Dr - West				
X Coordinate:	-121.31154				
Y Coordinate:	38.70929				
Barrier Area:	Sidewalks				
Barrier Type:	Driveway - Existing (5.0% or more)				
Code Ref:	CBC 1133B.7.1.3 and ADA/ABA 403.3

As Built Meas:	37	Quantity:	LF		
Description:	Driveway cross slope exceeds 2.0% (5.0% or more)				
As Built Desc:	8.2% cross slope				
Solution:	Provide min. 48" wide level walkway through driveway				
Bar. Severity:	4 Low Severity	Cost Estimate:	\$4,625.00	Status:	
Implementation Priority:	4	Facility Function:			
Implementation Phase:		Implementation Date:			
Official Responsible:					
Notes:

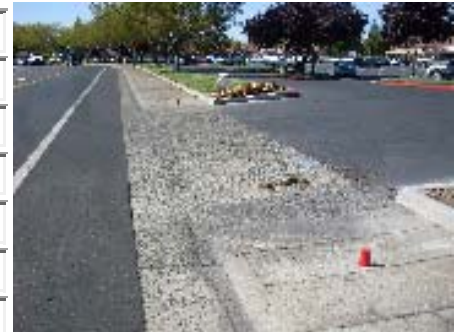
Field Date:	#####	Report Date:	10/12/2010	Barrier #:	524
Location:	Lichen Dr - North				
X Coordinate:	-121.31193				
Y Coordinate:	38.70859				
Barrier Area:	Sidewalks				
Barrier Type:	Driveway - Existing (5.0% or more)				
Code Ref:	CBC 1133B.7.1.3 and ADA/ABA 403.3

As Built Meas:	33	Quantity:	LF
Description:	Driveway cross slope exceeds 2.0% (5.0% or more)		
As Built Desc:	8.4% cross slope		
Solution:	Provide min. 48" wide level walkway through driveway		
Bar. Severity:	4 Low Severity	Cost Estimate:	\$4,125.00
Implementation Priority:	2	Facility Function:	
Implementation Phase:		Implementation Date:	
Official Responsible:			
Notes:

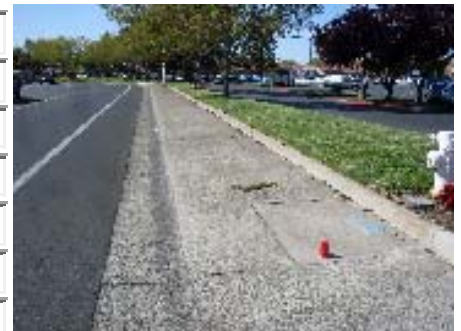
Field Date:	#####	Report Date:	10/12/2010	Barrier #:	525
Location:	Lichen Dr - North				
X Coordinate:	-121.31203				
Y Coordinate:	38.70858				
Barrier Area:	Sidewalks				
Barrier Type:	Cross Slope - Existing (4.1% to 4.9%)				
Code Ref:	CBC 1133B.7.1.3 and ADA/ABA 403.3

As Built Meas:	425	Quantity:	LF
Description:	Cross slope exceeds 2.0% (4.1% to 4.9%)		
As Built Desc:	4.5% cross slope		
Solution:	Demolish existing and construct new route		
Bar. Severity:	2 Recommended	Cost Estimate:	\$53,125.00
Implementation Priority:	2	Facility Function:	
Implementation Phase:		Implementation Date:	
Official Responsible:			
Notes:

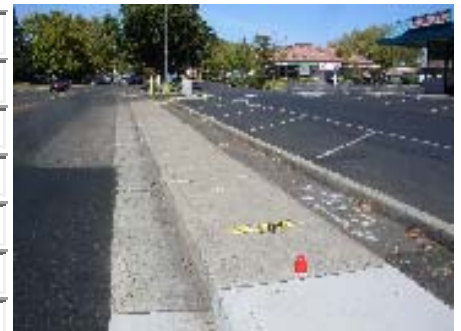
Field Date:	#####	Report Date:	10/12/2010	Barrier #:	527
Location:	Zenith Dr - East				
X Coordinate:	-121.31538				
Y Coordinate:	38.70775				
Barrier Area:	Sidewalks				
Barrier Type:	Cross Slope - Existing (3.1% to 4.0%)				
Code Ref:	CBC 1133B.7.1.3 and ADA/ABA 403.3

As Built Meas:	91	Quantity:	LF
Description:	Cross slope exceeds 2.0% (3.1% to 4.0%)		
As Built Desc:	3.5% cross slope		
Solution:	Demolish existing and construct new route		
Bar. Severity:	3 Hindrance	Cost Estimate:	\$11,375.00
Implementation Priority:	3	Facility Function:	
Implementation Phase:		Implementation Date:	
Official Responsible:			
Notes:

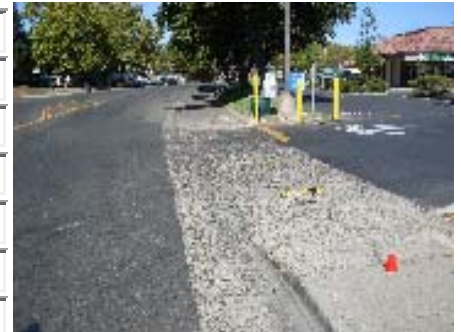
Field Date:	#####	Report Date:	10/12/2010	Barrier #:	528
Location:	Zenith Dr - East				
X Coordinate:	-121.31533				
Y Coordinate:	38.70802				
Barrier Area:	Sidewalks				
Barrier Type:	Driveway - Existing (5.0% or more)				
Code Ref:	CBC 1133B.7.1.3 and ADA/ABA 403.3

As Built Meas:	38	Quantity:	LF
Description:	Driveway cross slope exceeds 2.0% (5.0% or more)		
As Built Desc:	8.8% cross slope		
Solution:	Provide min. 48" wide level walkway through driveway		
Bar. Severity:	4 Low Severity	Cost Estimate:	\$4,750.00
Implementation Priority:	3	Facility Function:	
Implementation Phase:		Implementation Date:	
Official Responsible:			
Notes:

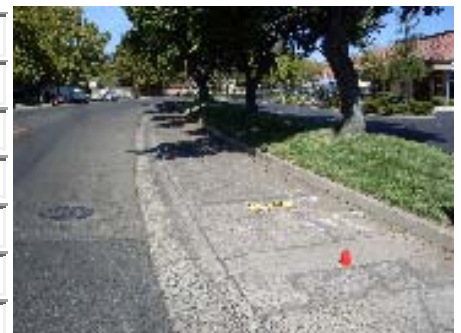
Field Date:	#####	Report Date:	10/12/2010	Barrier #:	529
Location:	Zenith Dr - East				
X Coordinate:	-121.31537				
Y Coordinate:	38.70805				
Barrier Area:	Sidewalks				
Barrier Type:	Cross Slope - Existing (5.0% or more)				
Code Ref:	CBC 1133B.7.1.3 and ADA/ABA 403.3

As Built Meas:	192	Quantity:	LF
Description:	Cross slope exceeds 2.0% (5.0% or more)		
As Built Desc:	5.2% cross slope		
Solution:	Demolish existing and construct new route		
Bar. Severity:	1 Necessary	Cost Estimate:	\$24,000.00
Implementation Priority:	3	Facility Function:	
Implementation Phase:		Implementation Date:	
Official Responsible:			
Notes:

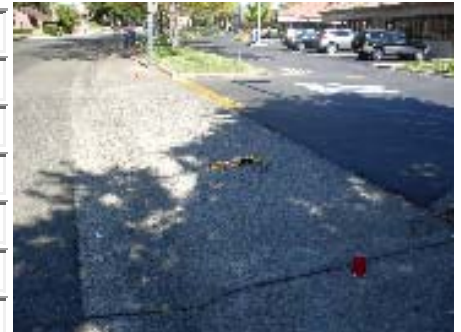
Field Date:	#####	Report Date:	10/12/2010	Barrier #:	530
Location:	Zenith Dr - East				
X Coordinate:	-121.31526				
Y Coordinate:	38.70863				
Barrier Area:	Sidewalks				
Barrier Type:	Driveway - Existing (5.0% or more)				
Code Ref:	CBC 1133B.7.1.3 and ADA/ABA 403.3

As Built Meas:	38	Quantity:	LF
Description:	Driveway cross slope exceeds 2.0% (5.0% or more)		
As Built Desc:	7.8% cross slope		
Solution:	Provide min. 48" wide level walkway through driveway		
Bar. Severity:	4 Low Severity	Cost Estimate:	\$4,750.00
Implementation Priority:	3	Facility Function:	
Implementation Phase:		Implementation Date:	
Official Responsible:			
Notes:

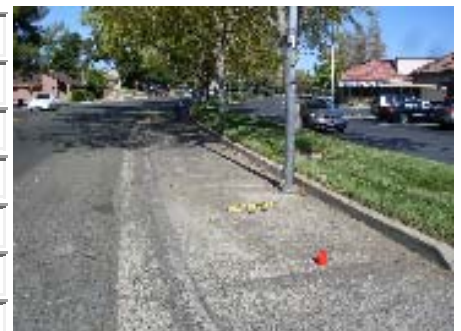
Field Date:	#####	Report Date:	10/12/2010	Barrier #:	531A
Location:	Zenith Dr - East				
X Coordinate:	-121.31521				
Y Coordinate:	38.70872				
Barrier Area:	Sidewalks				
Barrier Type:	Cross Slope - Existing (5.0% or more)				
Code Ref:	CBC 1133B.7.1.3 and ADA/ABA 403.3

As Built Meas:	202	Quantity:	LF
Description:	Cross slope exceeds 2.0% (5.0% or more)		
As Built Desc:	6.1% cross slope		
Solution:	Demolish existing and construct new route		
Bar. Severity:	1 Necessary	Cost Estimate:	\$25,250.00
Implementation Priority:	3	Facility Function:	
Implementation Phase:		Implementation Date:	
Official Responsible:			
Notes:

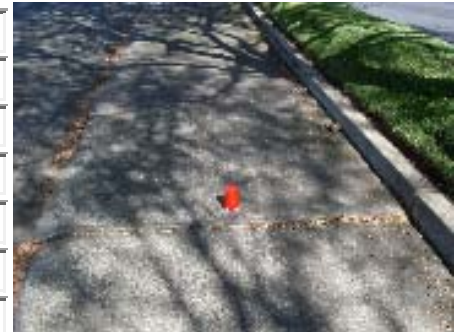
Field Date:	#####	Report Date:	10/12/2010	Barrier #:	531B
Location:	Zenith Dr - East				
X Coordinate:	-121.31493				
Y Coordinate:	38.70919				
Barrier Area:	Sidewalks				
Barrier Type:	Abrupt Change in Level - Tree Heaves				
Code Ref:	CBC 1133B.7.1 and ADA/ABA 303.3

As Built Meas:	5	Quantity:	LF
Description:	Change in level greater than 1/2"		
As Built Desc:	1" lip due to tree heaves		
Solution:	Grind or repair sidewalk to remove trip hazard		
Bar. Severity:	1 Necessary	Cost Estimate:	\$1,250.00
Implementation Priority:	3	Facility Function:	
Implementation Phase:		Implementation Date:	
Official Responsible:			
Notes:

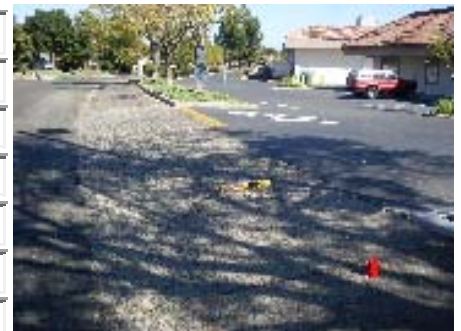
Field Date:	#####	Report Date:	10/12/2010	Barrier #:	532
Location:	Zenith Dr - East				
X Coordinate:	-121.31447				
Y Coordinate:	38.70958				
Barrier Area:	Sidewalks				
Barrier Type:	Driveway - Existing (5.0% or more)				
Code Ref:	CBC 1133B.7.1.3 and ADA/ABA 403.3

As Built Meas:	38	Quantity:	LF
Description:	Driveway cross slope exceeds 2.0% (5.0% or more)		
As Built Desc:	6.7% cross slope		
Solution:	Provide min. 48" wide level walkway through driveway		
Bar. Severity:	4 Low Severity	Cost Estimate:	\$4,750.00
Implementation Priority:	3	Facility Function:	
Implementation Phase:		Implementation Date:	
Official Responsible:			
Notes:

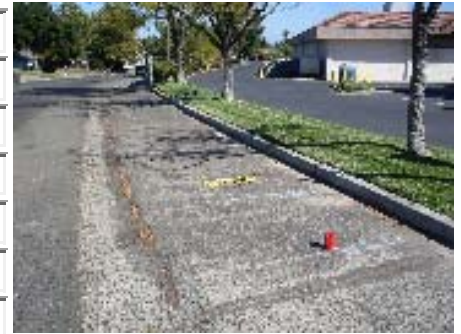
Field Date:	#####	Report Date:	10/12/2010	Barrier #:	533
Location:	Zenith Dr - East				
X Coordinate:	-121.31436				
Y Coordinate:	38.70966				
Barrier Area:	Sidewalks				
Barrier Type:	Cross Slope - Existing (5.0% or more)				
Code Ref:	CBC 1133B.7.1.3 and ADA/ABA 403.3

As Built Meas:	428	Quantity:	LF		
Description:	Cross slope exceeds 2.0% (5.0% or more)				
As Built Desc:	5.0% cross slope				
Solution:	Demolish existing and construct new route				
Bar. Severity:	1 Necessary	Cost Estimate:	\$53,500.00	Status:	
Implementation Priority:	3	Facility Function:			
Implementation Phase:		Implementation Date:			
Official Responsible:					
Notes:

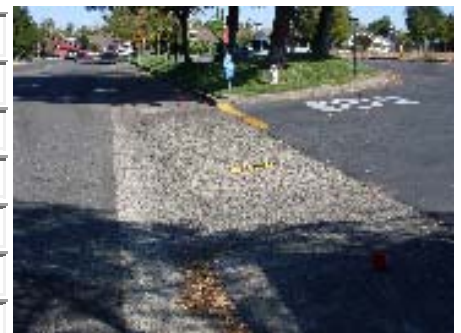
Field Date:	#####	Report Date:	10/12/2010	Barrier #:	534
Location:	Zenith Dr - East				
X Coordinate:	-121.31300				
Y Coordinate:	38.71014				
Barrier Area:	Sidewalks				
Barrier Type:	Driveway - Existing (5.0% or more)				
Code Ref:	CBC 1133B.7.1.3 and ADA/ABA 403.3

As Built Meas:	38	Quantity:	LF		
Description:	Driveway cross slope exceeds 2.0% (5.0% or more)				
As Built Desc:	7.9% cross slope				
Solution:	Provide min. 48" wide level walkway through driveway				
Bar. Severity:	4 Low Severity	Cost Estimate:	\$4,750.00	Status:	
Implementation Priority:	3	Facility Function:			
Implementation Phase:		Implementation Date:			
Official Responsible:					
Notes:

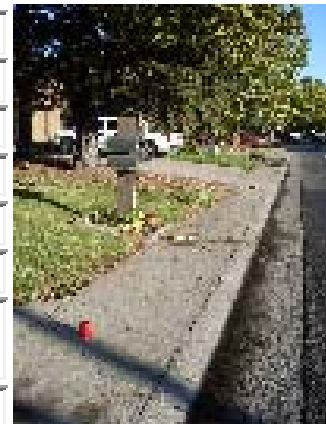
Field Date:	#####	Report Date:	10/13/2010	Barrier #:	536A
Location:	Zenith Dr - West				
X Coordinate:	-121.31551				
Y Coordinate:	38.70762				
Barrier Area:	Sidewalks				
Barrier Type:	Cross Slope - Existing (5.0% or more)				
Code Ref:	CBC 1133B.7.1.3 and ADA/ABA 403.3

As Built Meas:	207	Quantity:	LF
Description:	Cross slope exceeds 2.0% (5.0% or more)		
As Built Desc:	8.0% cross slope		
Solution:	Demolish existing and construct new route		
Bar. Severity:	1 Necessary	Cost Estimate:	\$25,875.00
Implementation Priority:	3	Facility Function:	
Implementation Phase:		Implementation Date:	
Official Responsible:			
Notes:

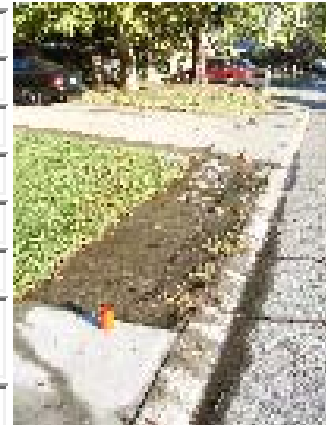
Barrier Type: Surface Condition - Damaged

Description: Surface is not firm and stable (cracked, broken or loose soil, etc.)

As Built Desc: Cracked concrete

Solution: Repair surface to make firm and stable

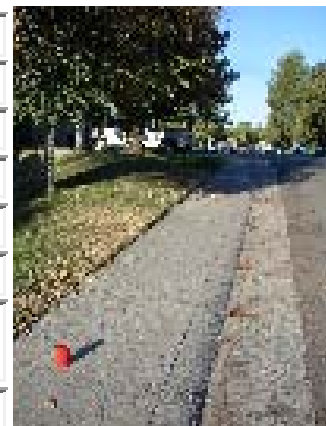
Barrier Type: Cross Slope - Existing (5.0% or more)

Description: Cross slope exceeds 2.0% (5.0% or more)

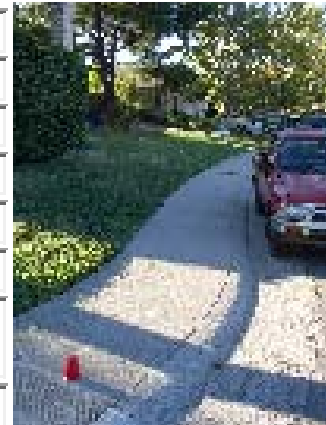
Barrier Type: Cross Slope - Existing (5.0% or more)

Description: Cross slope exceeds 2.0% (5.0% or more)

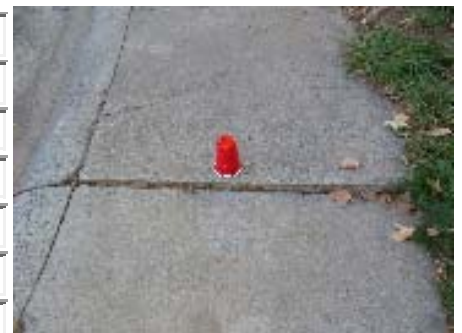
Barrier Type: Abrupt Change in Level - Tree Heaves

Description: Change in level greater than 1/2"

Solution: Grind or repair sidewalk to remove trip hazard

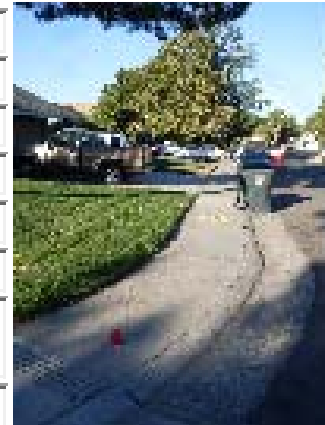
Field Date:	#####	Report Date:	10/13/2010	Barrier #:	540
Location:	Blackstar Dr - South				
X Coordinate:	-121.31634				
Y Coordinate:	38.70830				
Barrier Area:	Sidewalks				
Barrier Type:	Cross Slope - Existing (5.0% or more)				
Code Ref:	CBC 1133B.7.1.3 and ADA/ABA 403.3

As Built Meas:	312	Quantity:	LF
Description:	Cross slope exceeds 2.0% (5.0% or more)		
As Built Desc:	5.4% cross slope		
Solution:	Demolish existing and construct new route		
Bar. Severity:	1 Necessary	Cost Estimate:	\$39,000.00
Implementation Priority:	4	Facility Function:	
Implementation Phase:		Implementation Date:	
Official Responsible:			
Notes:

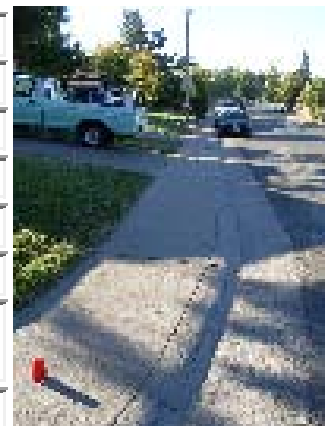
Field Date:	#####	Report Date:	10/13/2010	Barrier #:	541A
Location:	Summerplace Dr - East				
X Coordinate:	-121.31741				
Y Coordinate:	38.70834				
Barrier Area:	Sidewalks				
Barrier Type:	Cross Slope - Existing (5.0% or more)				
Code Ref:	CBC 1133B.7.1.3 and ADA/ABA 403.3

As Built Meas:	279	Quantity:	LF
Description:	Cross slope exceeds 2.0% (5.0% or more)		
As Built Desc:	5.3% cross slope		
Solution:	Demolish existing and construct new route		
Bar. Severity:	1 Necessary	Cost Estimate:	\$34,875.00
Implementation Priority:	4	Facility Function:	
Implementation Phase:		Implementation Date:	
Official Responsible:			
Notes:

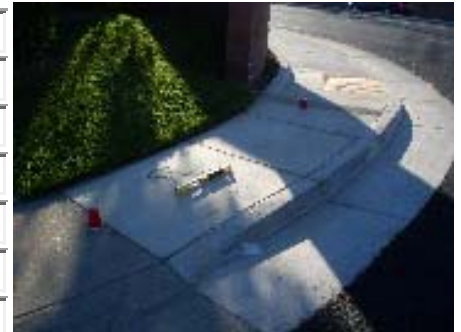
Field Date:	#####	Report Date:	10/13/2010	Barrier #:	541B
Location:	Summerplace Dr - East				
X Coordinate:	-121.31747				
Y Coordinate:	38.70753				
Barrier Area:	Sidewalks				
Barrier Type:	Running Slope (Existing)				
Code Ref:	CBC 1133B.7.3 and ADA/ABA 403.3

As Built Meas:	11	Quantity:	LF
Description:	Running slope exceeds 5.0%		
As Built Desc:	10.7% running slope		
Solution:	No remediation where sidewalk sloped as roadway		
Bar. Severity:	5 Technically Infeasible	Cost Estimate:	\$0.00
Implementation Priority:	4	Facility Function:	
Implementation Phase:		Implementation Date:	
Official Responsible:			
Notes:

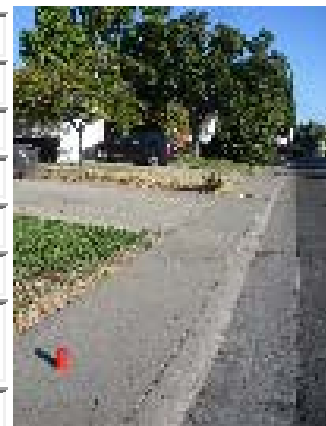
Field Date:	#####	Report Date:	10/13/2010	Barrier #:	542
Location:	Summerplace Dr - West				
X Coordinate:	-121.31765				
Y Coordinate:	38.70803				
Barrier Area:	Sidewalks				
Barrier Type:	Cross Slope - Existing (5.0% or more)				
Code Ref:	CBC 1133B.7.1.3 and ADA/ABA 403.3

As Built Meas:	373	Quantity:	LF
Description:	Cross slope exceeds 2.0% (5.0% or more)		
As Built Desc:	5.8% cross slope		
Solution:	Demolish existing and construct new route		
Bar. Severity:	1 Necessary	Cost Estimate:	\$46,625.00
Implementation Priority:	4	Facility Function:	
Implementation Phase:		Implementation Date:	
Official Responsible:			
Notes:

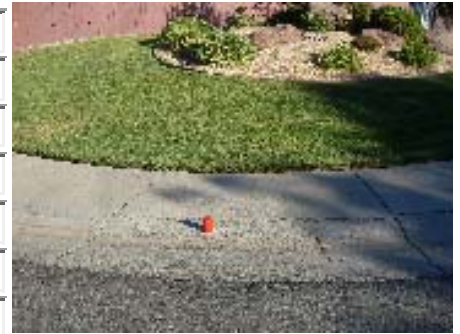
Field Date:	#####	Report Date:	10/13/2010	Barrier #:	543
Location:	Summerplace Dr and Reina Ct - Corner A				
X Coordinate:	-121.31731				
Y Coordinate:	38.70909				
Barrier Area:	Curb Ramps				
Barrier Type:	No Curb Ramp - Depressed Exsiting Curb				
Code Ref:	CBC 1127B.5.1 and ADA/ABA 402.2

As Built Meas:	1	Quantity:	EACH		
Description:	No compliant curb cut at corner (intersection)				
As Built Desc:	13.4% running slope at depressed area				
Solution:	Demolish existing and construct curb cut				
Bar. Severity:	1 Necessary	Cost Estimate:	\$2,500.00	Status:	
Implementation Priority:	4	Facility Function:			
Implementation Phase:		Implementation Date:			
Official Responsible:					
Notes:	Two - way intersection corners A,D

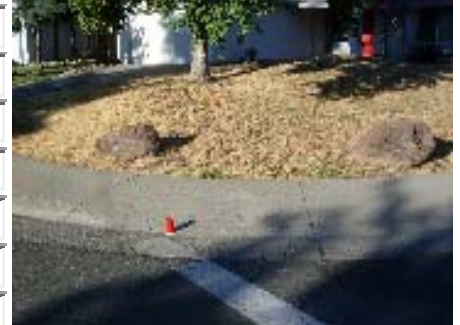
Field Date:	#####	Report Date:	10/13/2010	Barrier #:	544
Location:	Summerplace Dr and Reina Ct - Corner D				
X Coordinate:	-121.31739				
Y Coordinate:	38.70898				
Barrier Area:	Curb Ramps				
Barrier Type:	No Curb Ramp - Depressed Exsiting Curb				
Code Ref:	CBC 1127B.5.1 and ADA/ABA 402.2

As Built Meas:	1	Quantity:	EACH		
Description:	No compliant curb cut at corner (intersection)				
As Built Desc:	10.7% running slope at depressed area				
Solution:	Demolish existing and construct curb cut				
Bar. Severity:	1 Necessary	Cost Estimate:	\$2,500.00	Status:	
Implementation Priority:	4	Facility Function:			
Implementation Phase:		Implementation Date:			
Official Responsible:					
Notes:	Two - way intersection corners A,D

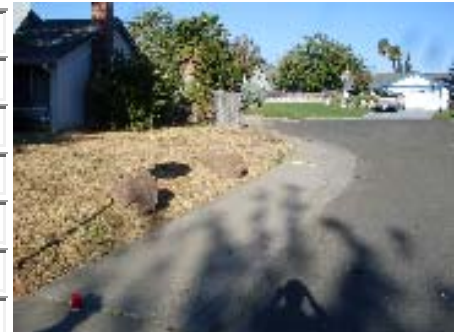
Field Date:	#####	Report Date:	10/13/2010	Barrier #:	545
Location:	Reina Ct - South				
X Coordinate:	-121.31741				
Y Coordinate:	38.70899				
Barrier Area:	Sidewalks				
Barrier Type:	Cross Slope - Existing (5.0% or more)				
Code Ref:	CBC 1133B.7.1.3 and ADA/ABA 403.3

As Built Meas:	110	Quantity:	LF		
Description:	Cross slope exceeds 2.0% (5.0% or more)				
As Built Desc:	5.0% cross slope				
Solution:	Demolish existing and construct new route				
Bar. Severity:	1 Necessary	Cost Estimate:	\$13,750.00	Status:	
Implementation Priority:	4	Facility Function:			
Implementation Phase:		Implementation Date:			
Official Responsible:

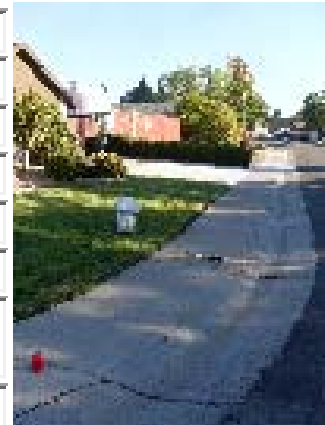
Field Date:	#####	Report Date:	10/13/2010	Barrier #:	547
Location:	Summerplace Dr - West				
X Coordinate:	-121.31730				
Y Coordinate:	38.70910				
Barrier Area:	Sidewalks				
Barrier Type:	Cross Slope - Existing (4.1% to 4.9%)				
Code Ref:	CBC 1133B.7.1.3 and ADA/ABA 403.3

As Built Meas:	194	Quantity:	LF
Description:	Cross slope exceeds 2.0% (4.1% to 4.9%)		
As Built Desc:	4.7% cross slope		
Solution:	Demolish existing and construct new route		
Bar. Severity:	2 Recommended	Cost Estimate:	\$24,250.00
Implementation Priority:	4	Facility Function:	
Implementation Phase:		Implementation Date:	
Official Responsible:

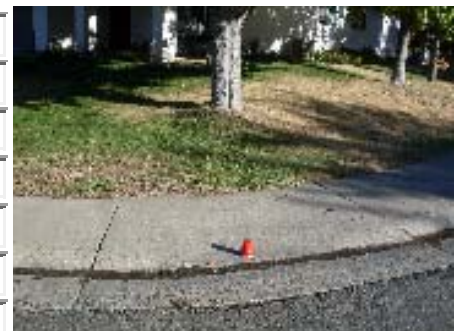
Field Date:	#####	Report Date:	10/13/2010	Barrier #:	548
Location:	Summerplace Dr and Sandridge Dr - Corner A				
X Coordinate:	-121.31677				
Y Coordinate:	38.70961				
Barrier Area:	Curb Ramps				
Barrier Type:	No Curb Ramp - Depressed Existing Curb				
Code Ref:	CBC 1127B.5.1 and ADA/ABA 402.2

As Built Meas:	1	Quantity:	EACH
Description:	No compliant curb cut at corner (intersection)		
As Built Desc:	10.2% running slope at depressed area		
Solution:	Demolish existing and construct curb cut		
Bar. Severity:	1 Necessary	Cost Estimate:	\$2,500.00
Implementation Priority:	4	Facility Function:	
Implementation Phase:		Implementation Date:	
Official Responsible:

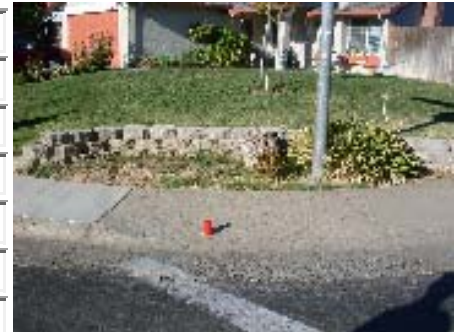
Field Date:	#####	Report Date:	10/13/2010	Barrier #:	549
Location:	Summerplace Dr and Sandridge Dr - Corner D				
X Coordinate:	-121.31686				
Y Coordinate:	38.70953				
Barrier Area:	Curb Ramps				
Barrier Type:	No Curb Ramp - Depressed Exsiting Curb				
Code Ref:	CBC 1127B.5.1 and ADA/ABA 402.2

As Built Meas:	1	Quantity:	EACH
Description:	No compliant curb cut at corner (intersection)		
As Built Desc:	10.7% running slope at depressed area		
Solution:	Demolish existing and construct curb cut		
Bar. Severity:	1 Necessary	Cost Estimate:	\$2,500.00
Implementation Priority:	4	Facility Function:	
Implementation Phase:		Implementation Date:	
Official Responsible:			
Notes:	Two - way intersection corners A,D
