DRAFT ADA TRANSITION PLAN UPDATE
NEIGHBORHOOD AREA 1 NORTHWEST
SEPTEMBER 20, 2011

CITY OF CITRUS HEIGHTS

The Northwest Neighborhood Association

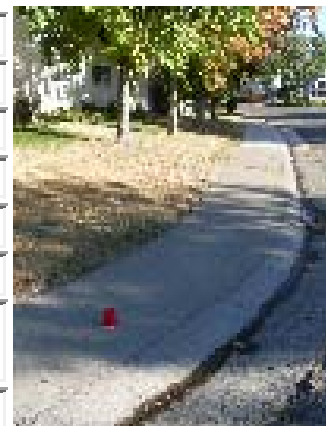
Field Date:	#####	Report Date:	10/13/2010	Barrier #:	550
Location:	Summerplace Dr - West				
X Coordinate:	-121.31675				
Y Coordinate:	38.70964				
Barrier Area:	Sidewalks				
Barrier Type:	Cross Slope - Existing (5.0% or more)				
Code Ref:	CBC 1133B.7.1.3 and ADA/ABA 403.3

As Built Meas:	254	Quantity:	LF
Description:	Cross slope exceeds 2.0% (5.0% or more)		
As Built Desc:	5.8% cross slope		
Solution:	Demolish existing and construct new route		
Bar. Severity:	1 Necessary	Cost Estimate:	\$31,750.00
Implementation Priority:	4	Facility Function:	
Implementation Phase:		Implementation Date:	
Official Responsible:			
Notes:

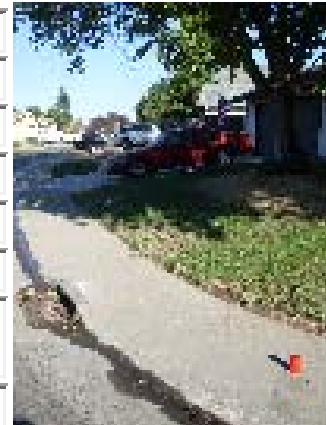
Field Date: ##### Report Date: 10/13/2010 Barrier #: 551A

Barrier Type: Cross Slope - Existing (5.0% or more)

As Built Meas: 832 Quantity: LF

Description: Cross slope exceeds 2.0% (5.0% or more)

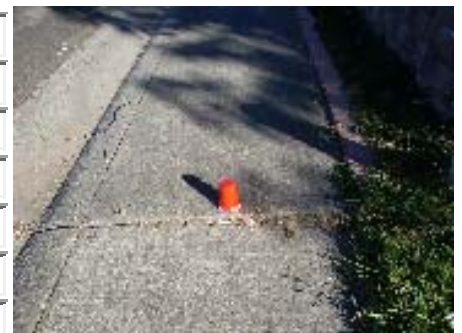
Barrier Type: Abrupt Change in Level - > 1/2"

As Built Meas: 4 Quantity: LF

Description: Change in level greater than 1/2"

Solution: Grind or repair sidewalk to remove trip hazard

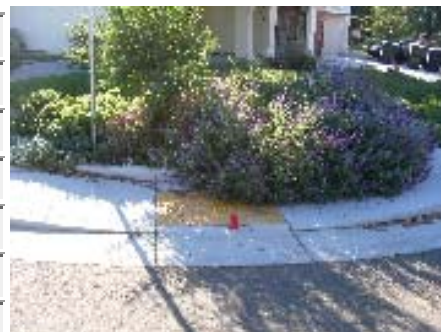
Barrier Type: Clear Width

As Built Meas: 1 Quantity: EACH

Description: Curb ramp not at least 48" wide

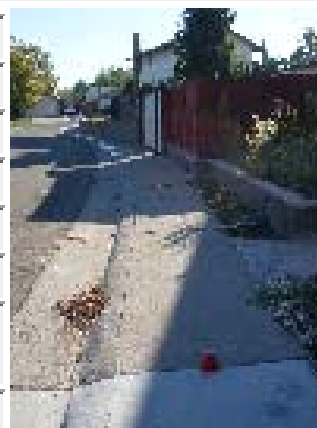
Barrier Type: Cross Slope - Existing (5.0% or more)

As Built Meas: 160 Quantity: LF

Description: Cross slope exceeds 2.0% (5.0% or more)

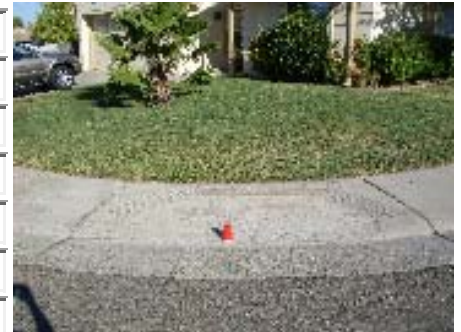
Field Date:	#####	Report Date:	10/13/2010	Barrier #:	556
Location:	Ericwood Ct and Lovewood Ct - Corner A				
X Coordinate:	-121.31899				
Y Coordinate:	38.71261				
Barrier Area:	Curb Ramps				
Barrier Type:	No Curb Ramp - Depressed Exsiting Curb				
Code Ref:	CBC 1127B.5.1 and ADA/ABA 402.2

As Built Meas:	1	Quantity:	EACH
Description:	No compliant curb cut at corner (intersection)		
As Built Desc:	11.7% running slope at depressed area		
Solution:	Demolish existing and construct curb cut		
Bar. Severity:	1 Necessary	Cost Estimate:	\$2,500.00
Implementation Priority:	4	Facility Function:	
Implementation Phase:		Implementation Date:	
Official Responsible:			
Notes:	Four - way intersection corners A,B,C,D

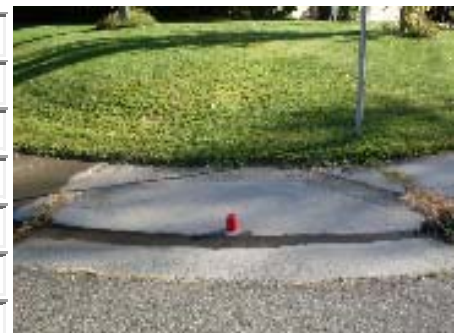
Field Date:	#####	Report Date:	10/13/2010	Barrier #:	557
Location:	Ericwood Ct and Lovewood Ct - Corner B				
X Coordinate:	-121.31885				
Y Coordinate:	38.71260				
Barrier Area:	Curb Ramps				
Barrier Type:	No Curb Ramp - Depressed Exsiting Curb				
Code Ref:	CBC 1127B.5.1 and ADA/ABA 402.2

As Built Meas:	1	Quantity:	EACH
Description:	No compliant curb cut at corner (intersection)		
As Built Desc:	11.8% running slope at depressed area		
Solution:	Demolish existing and construct curb cut		
Bar. Severity:	1 Necessary	Cost Estimate:	\$2,500.00
Implementation Priority:	4	Facility Function:	
Implementation Phase:		Implementation Date:	
Official Responsible:			
Notes:	Four - way intersection corners A,B,C,D

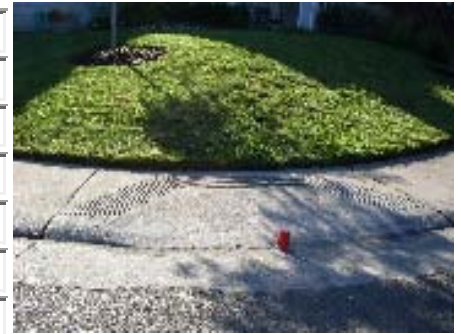
Field Date:	#####	Report Date:	10/13/2010	Barrier #:	558
Location:	Ericwood Ct and Lovewood Ct - Corner C				
X Coordinate:	-121.31894				
Y Coordinate:	38.71250				
Barrier Area:	Curb Ramps				
Barrier Type:	No Curb Ramp - Depressed Exsiting Curb				
Code Ref:	CBC 1127B.5.1 and ADA/ABA 402.2

As Built Meas:	1	Quantity:	EACH
Description:	No compliant curb cut at corner (intersection)		
As Built Desc:	11.7% running slope at depressed area		
Solution:	Demolish existing and construct curb cut		
Bar. Severity:	1 Necessary	Cost Estimate:	\$2,500.00
Implementation Priority:	4	Facility Function:	
Implementation Phase:		Implementation Date:	
Official Responsible:			
Notes:	Four - way intersection corners A,B,C,D

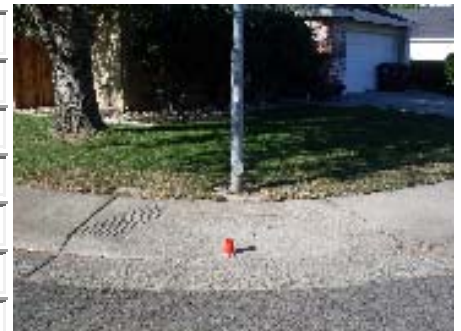
Field Date:	#####	Report Date:	10/13/2010	Barrier #:	559
Location:	Ericwood Ct and Lovewood Ct - Corner D				
X Coordinate:	-121.31908				
Y Coordinate:	38.71255				
Barrier Area:	Curb Ramps				
Barrier Type:	No Curb Ramp - Depressed Exsiting Curb				
Code Ref:	CBC 1127B.5.1 and ADA/ABA 402.2

As Built Meas:	1	Quantity:	EACH
Description:	No compliant curb cut at corner (intersection)		
As Built Desc:	9.7% running slope at depressd area		
Solution:	Demolish existing and construct curb cut		
Bar. Severity:	1 Necessary	Cost Estimate:	\$2,500.00
Implementation Priority:	4	Facility Function:	
Implementation Phase:		Implementation Date:	
Official Responsible:			
Notes:	Four - way intersection corners A,B,C,D

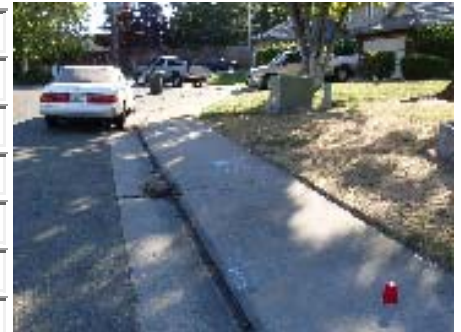
Field Date:	#####	Report Date:	10/13/2010	Barrier #:	560
Location:	Lovewood Ct - South				
X Coordinate:	-121.31892				
Y Coordinate:	38.71249				
Barrier Area:	Sidewalks				
Barrier Type:	Cross Slope - Existing (4.1% to 4.9%)				
Code Ref:	CBC 1133B.7.1.3 and ADA/ABA 403.3

As Built Meas:	140	Quantity:	LF
Description:	Cross slope exceeds 2.0% (4.1% to 4.9%)		
As Built Desc:	4.3% cross slope		
Solution:	Demolish existing and construct new route		
Bar. Severity:	2 Recommended	Cost Estimate:	\$17,500.00
Implementation Priority:	4	Facility Function:	
Implementation Phase:		Implementation Date:	
Official Responsible:			
Notes:

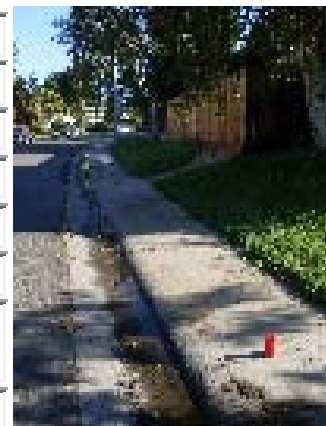
Field Date:	#####	Report Date:	10/13/2010	Barrier #:	561
Location:	Ericwood Ct - East				
X Coordinate:	-121.31885				
Y Coordinate:	38.71260				
Barrier Area:	Sidewalks				
Barrier Type:	Cross Slope - Existing (4.1% to 4.9%)				
Code Ref:	CBC 1133B.7.1.3 and ADA/ABA 403.3

As Built Meas:	99	Quantity:	LF
Description:	Cross slope exceeds 2.0% (4.1% to 4.9%)		
As Built Desc:	4.7% cross slope		
Solution:	Demolish existing and construct new route		
Bar. Severity:	2 Recommended	Cost Estimate:	\$12,375.00
Implementation Priority:	4	Facility Function:	
Implementation Phase:		Implementation Date:	
Official Responsible:			
Notes:

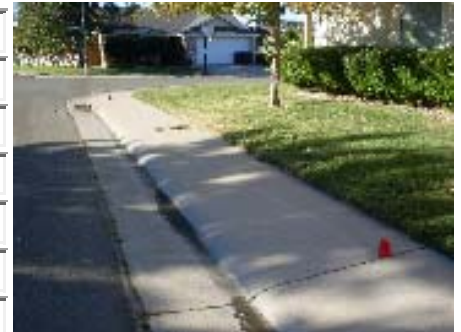
Field Date:	#####	Report Date:	10/13/2010	Barrier #:	562
Location:	Ericwood Ct - West				
X Coordinate:	-121.31892				
Y Coordinate:	38.71273				
Barrier Area:	Sidewalks				
Barrier Type:	Cross Slope - Existing (5.0% or more)				
Code Ref:	CBC 1133B.7.1.3 and ADA/ABA 403.3

As Built Meas:	58	Quantity:	LF
Description:	Cross slope exceeds 2.0% (5.0% or more)		
As Built Desc:	5.3% cross slope		
Solution:	Demolish existing and construct new route		
Bar. Severity:	1 Necessary	Cost Estimate:	\$7,250.00
Implementation Priority:	4	Facility Function:	
Implementation Phase:		Implementation Date:	
Official Responsible:			
Notes:

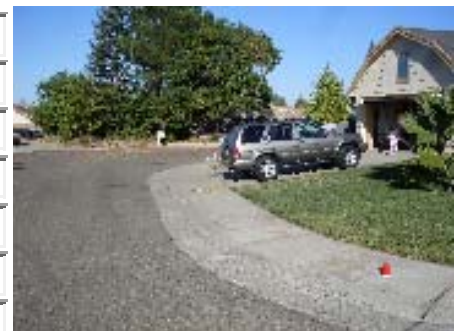
Field Date:	#####	Report Date:	10/13/2010	Barrier #:	563A
Location:	Starwood Ct - North				
X Coordinate:	-121.31903				
Y Coordinate:	38.71262				
Barrier Area:	Sidewalks				
Barrier Type:	Cross Slope - Existing (4.1% to 4.9%)				
Code Ref:	CBC 1133B.7.1.3 and ADA/ABA 403.3

As Built Meas:	160	Quantity:	LF
Description:	Cross slope exceeds 2.0% (4.1% to 4.9%)		
As Built Desc:	4.8% cross slope		
Solution:	Demolish existing and construct new route		
Bar. Severity:	2 Recommended	Cost Estimate:	\$20,000.00
Implementation Priority:	4	Facility Function:	
Implementation Phase:		Implementation Date:	
Official Responsible:			
Notes:

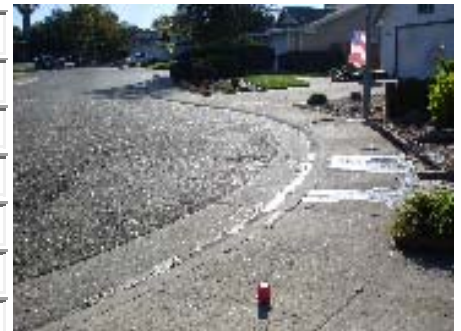
Field Date:	#####	Report Date:	10/13/2010	Barrier #:	564
Location:	Starwood Ct - South				
X Coordinate:	-121.31948				
Y Coordinate:	38.71278				
Barrier Area:	Sidewalks				
Barrier Type:	Cross Slope - Existing (4.1% to 4.9%)				
Code Ref:	CBC 1133B.7.1.3 and ADA/ABA 403.3

As Built Meas:	140	Quantity:	LF
Description:	Cross slope exceeds 2.0% (4.1% to 4.9%)		
As Built Desc:	4.9% cross slope		
Solution:	Demolish existing and construct new route		
Bar. Severity:	2 Recommended	Cost Estimate:	\$17,500.00
Implementation Priority:	4	Facility Function:	
Implementation Phase:		Implementation Date:	
Official Responsible:			
Notes:

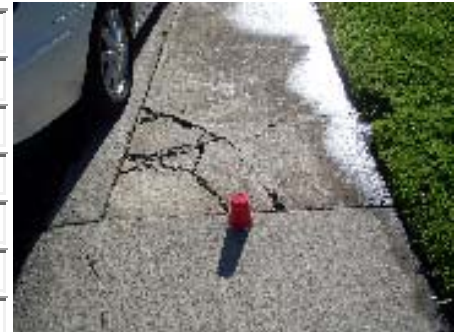
Field Date:	#####	Report Date:	10/13/2010	Barrier #:	565
Location:	Wallwood Ct - South				
X Coordinate:	-121.32002				
Y Coordinate:	38.71202				
Barrier Area:	Sidewalks				
Barrier Type:	Surface Condition - Damaged				
Code Ref:	CBC 1133B.7.1 and ADA/ABA 302.1

As Built Meas:	4	Quantity:	LF
Description:	Surface is not firm and stable (cracked, broken or loose soil, etc.)		
As Built Desc:	Cracked concrete		
Solution:	Repair surface to make firm and stable		
Bar. Severity:	1 Necessary	Cost Estimate:	\$500.00
Implementation Priority:	4	Facility Function:	
Implementation Phase:		Implementation Date:	
Official Responsible:			
Notes:

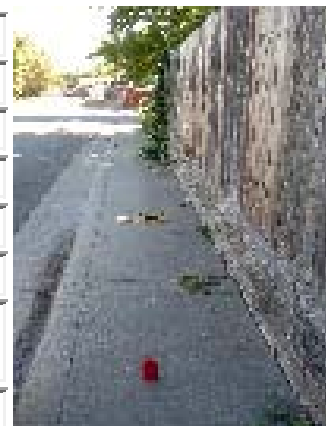
Field Date:	#####	Report Date:	10/13/2010	Barrier #:	566
Location:	Mesaview Dr - South				
X Coordinate:	-121.31872				
Y Coordinate:	38.71186				
Barrier Area:	Sidewalks				
Barrier Type:	Cross Slope - Existing (5.0% or more)				
Code Ref:	CBC 1133B.7.1.3 and ADA/ABA 403.3

As Built Meas:	70	Quantity:	LF
Description:	Cross slope exceeds 2.0% (5.0% or more)		
As Built Desc:	5.2% cross slope		
Solution:	Demolish existing and construct new route		
Bar. Severity:	1 Necessary	Cost Estimate:	\$8,750.00
Implementation Priority:	4	Facility Function:	
Implementation Phase:		Implementation Date:	
Official Responsible:			
Notes:

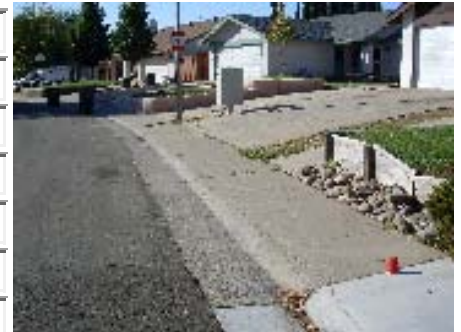
Field Date:	#####	Report Date:	10/13/2010	Barrier #:	567
Location:	Sandridge Wy - West				
X Coordinate:	-121.31770				
Y Coordinate:	38.71176				
Barrier Area:	Sidewalks				
Barrier Type:	Cross Slope - Existing (5.0% or more)				
Code Ref:	CBC 1133B.7.1.3 and ADA/ABA 403.3

As Built Meas:	241	Quantity:	LF
Description:	Cross slope exceeds 2.0% (5.0% or more)		
As Built Desc:	6.0% cross slope		
Solution:	Demolish existing and construct new route		
Bar. Severity:	1 Necessary	Cost Estimate:	\$30,125.00
Implementation Priority:	4	Facility Function:	
Implementation Phase:		Implementation Date:	
Official Responsible:

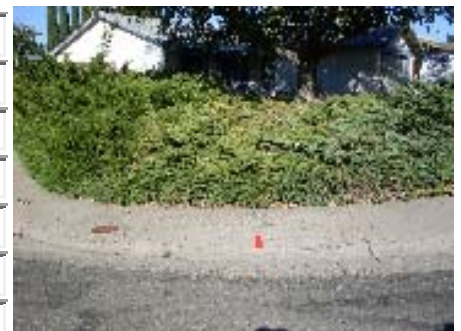
Field Date:	#####	Report Date:	10/13/2010	Barrier #:	568
Location:	Sandridge Wy and Autumn Ct - Corner A				
X Coordinate:	-121.31751				
Y Coordinate:	38.71112				
Barrier Area:	Curb Ramps				
Barrier Type:	No Curb Ramp - Depressed Existing Curb				
Code Ref:	CBC 1127B.5.1 and ADA/ABA 402.2

As Built Meas:	1	Quantity:	EACH
Description:	No compliant curb cut at corner (intersection)		
As Built Desc:	12.1% running slope at depressed area		
Solution:	Demolish existing and construct curb cut		
Bar. Severity:	1 Necessary	Cost Estimate:	\$2,500.00
Implementation Priority:	4	Facility Function:	
Implementation Phase:		Implementation Date:	
Official Responsible:

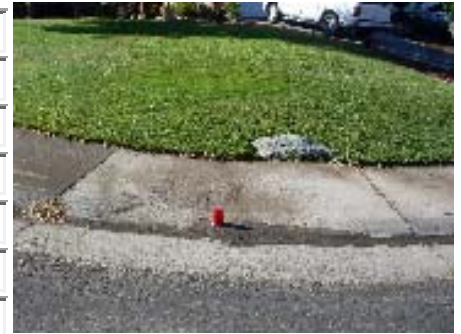
Barrier Type: No Curb Ramp - Depressed Exsiting Curb

Description: No compliant curb cut at corner (intersection)

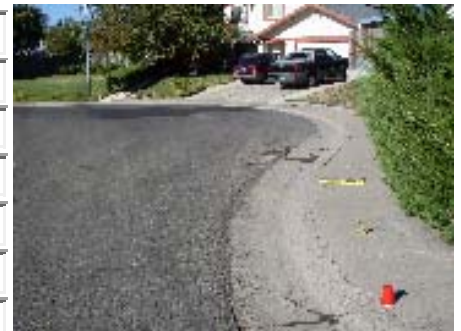
Barrier Type: Clear Width - Existing (32" to 35")

Description: Pedestrian route is not min. 48" wide (32" to 35")

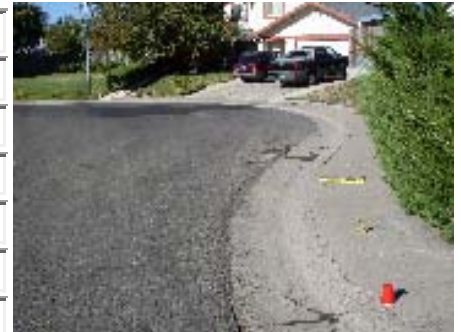
Field Date:	#####	Report Date:	10/13/2010	Barrier #:	570B
Location:	Autumn Ct - North				
X Coordinate:	-121.31759				
Y Coordinate:	38.71110				
Barrier Area:	Sidewalks				
Barrier Type:	Cross Slope - Existing (5.0% or more)				
Code Ref:	CBC 1133B.7.1.3 and ADA/ABA 403.3

As Built Meas:	117	Quantity:	LF
Description:	Cross slope exceeds 2.0% (5.0% or more)		
As Built Desc:	6.3% cross slope		
Solution:	Demolish existing and construct new route		
Bar. Severity:	1 Necessary	Cost Estimate:	\$14,625.00
Implementation Priority:	4	Facility Function:	
Implementation Phase:		Implementation Date:	
Official Responsible:			
Notes:

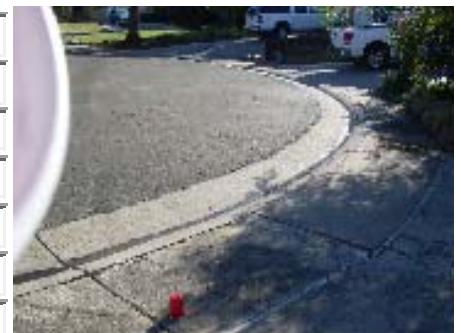
Field Date:	#####	Report Date:	10/13/2010	Barrier #:	571
Location:	Autumn Ct - South				
X Coordinate:	-121.31779				
Y Coordinate:	38.71095				
Barrier Area:	Sidewalks				
Barrier Type:	Cross Slope - Existing (5.0% or more)				
Code Ref:	CBC 1133B.7.1.3 and ADA/ABA 403.3

As Built Meas:	118	Quantity:	LF
Description:	Cross slope exceeds 2.0% (5.0% or more)		
As Built Desc:	7.1% cross slope		
Solution:	Demolish existing and construct new route		
Bar. Severity:	1 Necessary	Cost Estimate:	\$14,750.00
Implementation Priority:	4	Facility Function:	
Implementation Phase:		Implementation Date:	
Official Responsible:			
Notes:

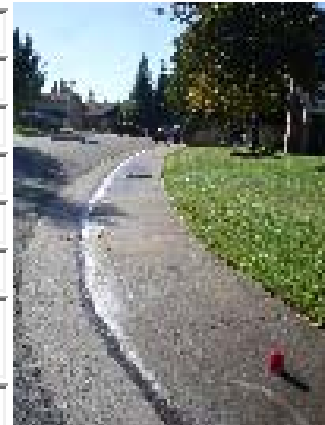
Barrier Type: Cross Slope - Existing (5.0% or more)

Description: Cross slope exceeds 2.0% (5.0% or more)

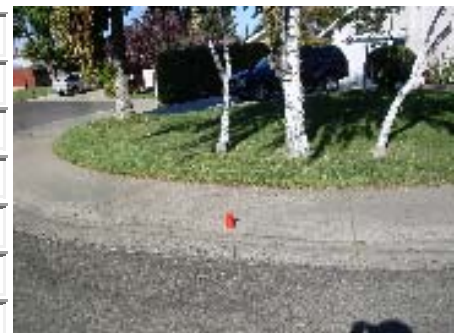
Barrier Type: No Curb Ramp - Depressed Existing Curb

Description: No compliant curb cut at corner (intersection)

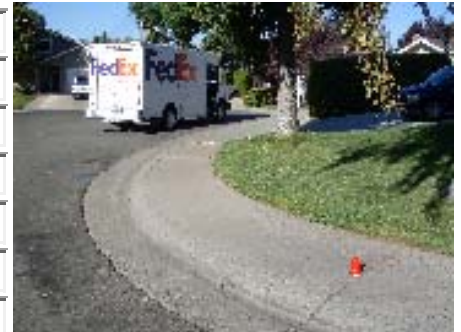
Field Date:	#####	Report Date:	10/13/2010	Barrier #:	574
Location:	Copa Ct - North				
X Coordinate:	-121.31735				
Y Coordinate:	38.71029				
Barrier Area:	Sidewalks				
Barrier Type:	Cross Slope - Existing (5.0% or more)				
Code Ref:	CBC 1133B.7.1.3 and ADA/ABA 403.3

As Built Meas:	147	Quantity:	LF		
Description:	Cross slope exceeds 2.0% (5.0% or more)				
As Built Desc:	6.4% cross slope				
Solution:	Demolish existing and construct new route				
Bar. Severity:	1 Necessary	Cost Estimate:	\$18,375.00	Status:	
Implementation Priority:	4	Facility Function:			
Implementation Phase:		Implementation Date:			
Official Responsible:					
Notes:

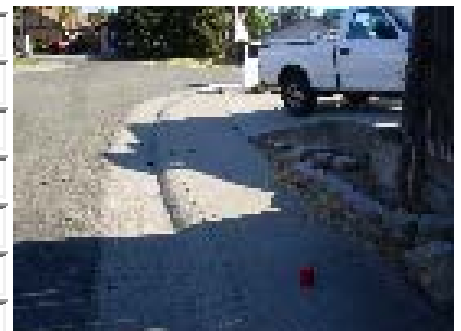
Field Date:	#####	Report Date:	10/13/2010	Barrier #:	575
Location:	Copa Ct - South				
X Coordinate:	-121.31747				
Y Coordinate:	38.71016				
Barrier Area:	Sidewalks				
Barrier Type:	Cross Slope - Existing (5.0% or more)				
Code Ref:	CBC 1133B.7.1.3 and ADA/ABA 403.3

As Built Meas:	56	Quantity:	LF		
Description:	Cross slope exceeds 2.0% (5.0% or more)				
As Built Desc:	5.3% cross slope				
Solution:	Demolish existing and construct new route				
Bar. Severity:	1 Necessary	Cost Estimate:	\$7,000.00	Status:	
Implementation Priority:	4	Facility Function:			
Implementation Phase:		Implementation Date:			
Official Responsible:					
Notes:

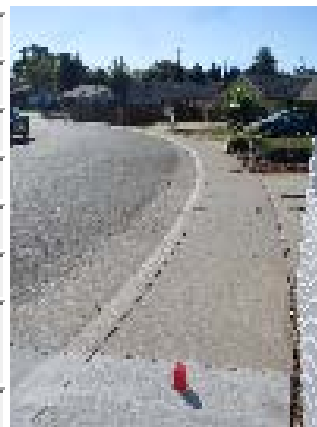
Barrier Type: Cross Slope - Existing (4.1% to 4.9%)

Description: Cross slope exceeds 2.0% (4.1% to 4.9%)

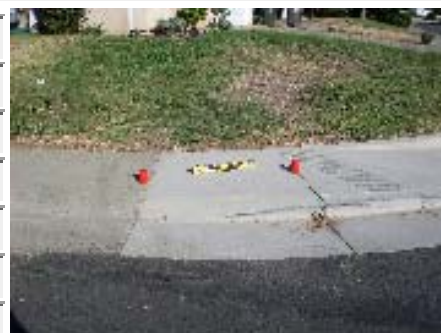
Barrier Type: Running Slope (New Construction)

Description: Running slope exceeds 5.0% where roadway slope does not

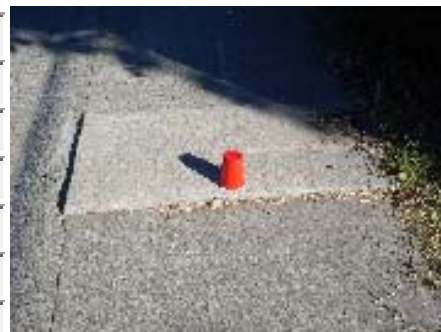
Field Date:	#####	Report Date:	10/13/2010	Barrier #:	578B
Location:	Ashmont St - East				
X Coordinate:	-121.31844				
Y Coordinate:	38.70931				
Barrier Area:	Sidewalks				
Barrier Type:	Abrupt Change in Level - > 1/2"				
Code Ref:	CBC 1133B.7.1 and ADA/ABA 303.3

As Built Meas:	4	Quantity:	LF
Description:	Change in level greater than 1/2"		
As Built Desc:	1" lip in sidewalk surface		
Solution:	Grind or repair sidewalk to remove trip hazard		
Bar. Severity:	1 Necessary	Cost Estimate:	\$1,000.00
Implementation Priority:	4	Facility Function:	
Implementation Phase:		Implementation Date:	
Official Responsible:			
Notes:

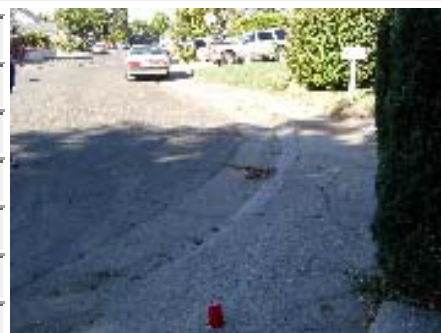
Field Date:	#####	Report Date:	10/13/2010	Barrier #:	579
Location:	Burntwood Wy - North				
X Coordinate:	-121.31851				
Y Coordinate:	38.71002				
Barrier Area:	Sidewalks				
Barrier Type:	Cross Slope - Existing (5.0% or more)				
Code Ref:	CBC 1133B.7.1.3 and ADA/ABA 403.3

As Built Meas:	586	Quantity:	LF
Description:	Cross slope exceeds 2.0% (5.0% or more)		
As Built Desc:	10.3% cross slope		
Solution:	Demolish existing and construct new route		
Bar. Severity:	1 Necessary	Cost Estimate:	\$73,250.00
Implementation Priority:	4	Facility Function:	
Implementation Phase:		Implementation Date:	
Official Responsible:			
Notes:

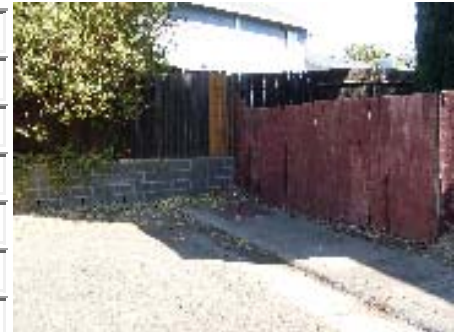
Field Date:	#####	Report Date:	10/13/2010	Barrier #:	582
Location:	Blazingwood Dr - East				
X Coordinate:	-121.32045				
Y Coordinate:	38.71028				
Barrier Area:	Curb Ramps				
Barrier Type:	No Curb Ramp				
Code Ref:	CBC 1127B.5.1 and ADA/ABA 402.2

As Built Meas:	1	Quantity:	EACH		
Description:	No curb cut at corner (intersection)				
As Built Desc:	No curb ramp at corner				
Solution:	Demolish existing and construct curb cut				
Bar. Severity:	1 Necessary	Cost Estimate:	\$2,500.00	Status:	
Implementation Priority:	4	Facility Function:			
Implementation Phase:		Implementation Date:			
Official Responsible:					
Notes:

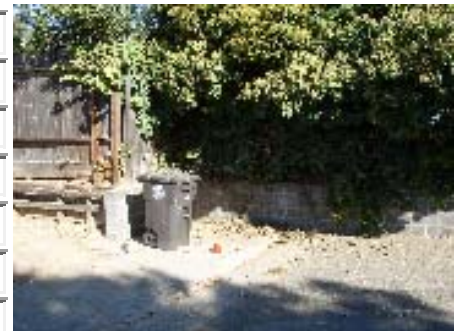
Field Date:	#####	Report Date:	10/13/2010	Barrier #:	583
Location:	Blazingwood Dr - West				
X Coordinate:	-121.32056				
Y Coordinate:	38.71035				
Barrier Area:	Curb Ramps				
Barrier Type:	No Curb Ramp				
Code Ref:	CBC 1127B.5.1 and ADA/ABA 402.2

As Built Meas:	1	Quantity:	EACH		
Description:	No curb cut at corner (intersection)				
As Built Desc:	No curb ramp at corner				
Solution:	Demolish existing and construct curb cut				
Bar. Severity:	1 Necessary	Cost Estimate:	\$2,500.00	Status:	
Implementation Priority:	4	Facility Function:			
Implementation Phase:		Implementation Date:			
Official Responsible:					
Notes:

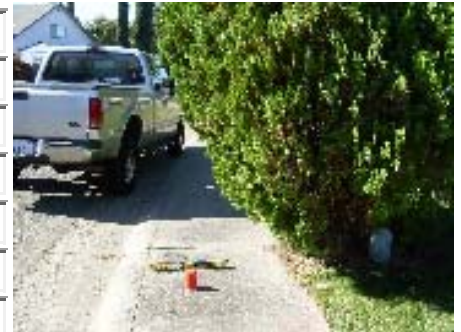
Field Date:	#####	Report Date:	10/13/2010	Barrier #:	584A
Location:	Blazingwood Dr - West				
X Coordinate:	-121.32057				
Y Coordinate:	38.71038				
Barrier Area:	Sidewalks				
Barrier Type:	Clear Width - Existing ($\leq 31"$ or less)				
Code Ref:	CBC 1133B.7.1

As Built Meas:	1	Quantity:	LF
Description:	Pedestrian route is not min. 48" wide ($\leq 31"$ or less)		
As Built Desc:	12" clear width due to foliage		
Solution:	Trim foliage to provide min. 48" clear width		
Bar. Severity:	1 Necessary	Cost Estimate:	\$125.00
Implementation Priority:	4	Facility Function:	
Implementation Phase:		Implementation Date:	
Official Responsible:			
Notes:

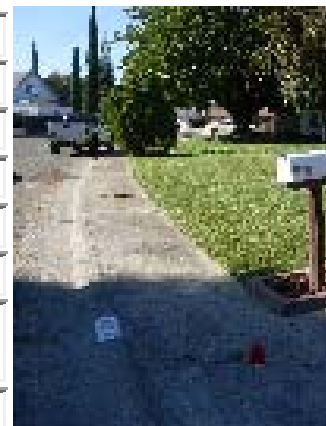
Field Date:	#####	Report Date:	10/13/2010	Barrier #:	584B
Location:	Blazingwood Dr - West				
X Coordinate:	-121.32066				
Y Coordinate:	38.71021				
Barrier Area:	Sidewalks				
Barrier Type:	Cross Slope - Existing (5.0% or more)				
Code Ref:	CBC 1133B.7.1.3 and ADA/ABA 403.3

As Built Meas:	210	Quantity:	LF
Description:	Cross slope exceeds 2.0% (5.0% or more)		
As Built Desc:	5.6% cross slope		
Solution:	Demolish existing and construct new route		
Bar. Severity:	1 Necessary	Cost Estimate:	\$26,250.00
Implementation Priority:	4	Facility Function:	
Implementation Phase:		Implementation Date:	
Official Responsible:			
Notes:

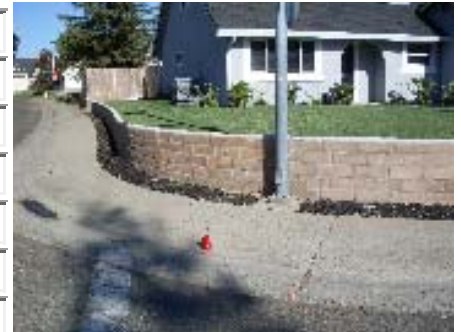
Field Date:	#####	Report Date:	10/13/2010	Barrier #:	585
Location:	Blazingwood Wy and Saybrook Dr - Corner A				
X Coordinate:	-121.32114				
Y Coordinate:	38.70992				
Barrier Area:	Curb Ramps				
Barrier Type:	No Curb Ramp - Depressed Exsiting Curb				
Code Ref:	CBC 1127B.5.1 and ADA/ABA 402.2

As Built Meas:	1	Quantity:	EACH
Description:	No compliant curb cut at corner (intersection)		
As Built Desc:	10.3% running slope at depressed area		
Solution:	Demolish existing and construct curb cut		
Bar. Severity:	1 Necessary	Cost Estimate:	\$2,500.00
Implementation Priority:	4	Facility Function:	
Implementation Phase:		Implementation Date:	
Official Responsible:			
Notes:	Two - way intersection corners A,B

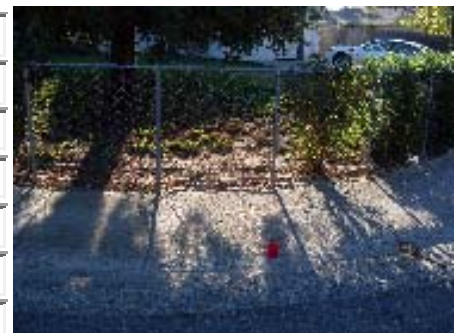
Field Date:	#####	Report Date:	10/14/2010	Barrier #:	586
Location:	Blazingwood Wy and Saybrook Dr - Corner B				
X Coordinate:	-121.32107				
Y Coordinate:	38.70977				
Barrier Area:	Curb Ramps				
Barrier Type:	No Curb Ramp - Depressed Exsiting Curb				
Code Ref:	CBC 1127B.5.1 and ADA/ABA 402.2

As Built Meas:	1	Quantity:	EACH
Description:	No compliant curb cut at corner (intersection)		
As Built Desc:	9.6% running slope at depressed curb		
Solution:	Demolish existing and construct curb cut		
Bar. Severity:	1 Necessary	Cost Estimate:	\$2,500.00
Implementation Priority:	4	Facility Function:	
Implementation Phase:		Implementation Date:	
Official Responsible:			
Notes:	Two - way intersection corners A,B

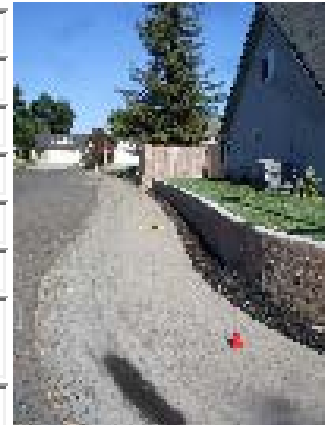
Barrier Type: Cross Slope - Existing (5.0% or more)

Description: Cross slope exceeds 2.0% (5.0% or more)

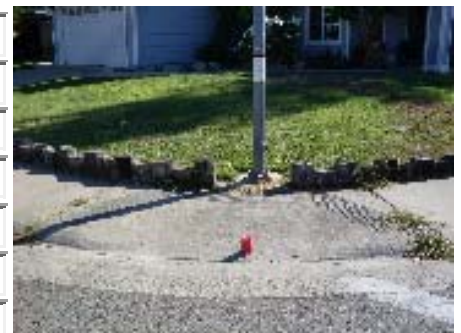
Barrier Type: No Curb Ramp - Depressed Existing Curb

Description: No compliant curb cut at corner (intersection)

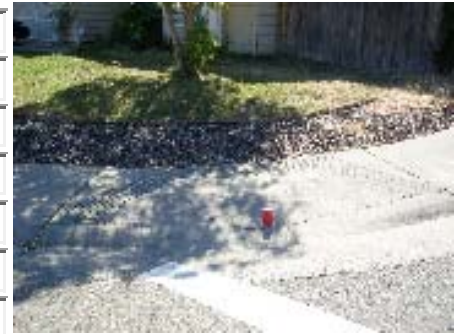
Field Date:	#####	Report Date:	10/13/2010	Barrier #:	589
Location:	Saybrook Dr and Brockwood Wy - Corner C				
X Coordinate:	-121.32176				
Y Coordinate:	38.71014				
Barrier Area:	Curb Ramps				
Barrier Type:	No Curb Ramp - Depressed Exsiting Curb				
Code Ref:	CBC 1127B.5.1 and ADA/ABA 402.2

As Built Meas:	1	Quantity:	EACH
Description:	No compliant curb cut at corner (intersection)		
As Built Desc:	10.2% running slope at depressed area		
Solution:	Demolish existing and construct curb cut		
Bar. Severity:	1 Necessary	Cost Estimate:	\$2,500.00
Implementation Priority:	4	Facility Function:	
Implementation Phase:		Implementation Date:	
Official Responsible:			
Notes:	Two - way intersection corners B,C

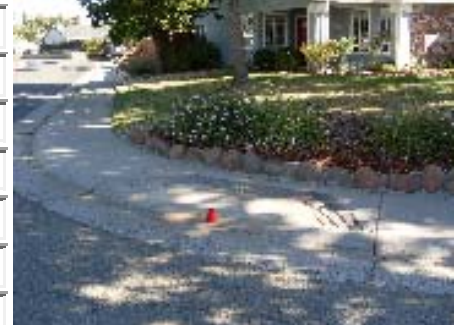
Field Date:	#####	Report Date:	10/13/2010	Barrier #:	590
Location:	Brockwood Wy and Annwood Ct - Corner B				
X Coordinate:	-121.31945				
Y Coordinate:	38.71083				
Barrier Area:	Curb Ramps				
Barrier Type:	No Curb Ramp - Depressed Exsiting Curb				
Code Ref:	CBC 1127B.5.1 and ADA/ABA 402.2

As Built Meas:	1	Quantity:	EACH
Description:	No compliant curb cut at corner (intersection)		
As Built Desc:	10.0% running slope at depressed area		
Solution:	Demolish existing and construct curb cut		
Bar. Severity:	1 Necessary	Cost Estimate:	\$2,500.00
Implementation Priority:	4	Facility Function:	
Implementation Phase:		Implementation Date:	
Official Responsible:			
Notes:	Two - way intersection corners B,C

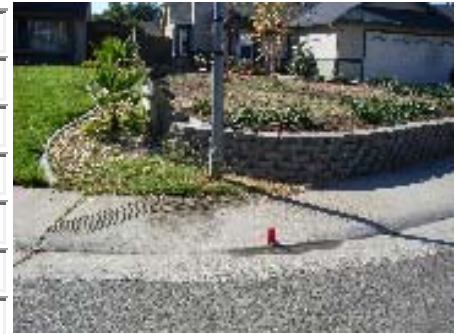
Field Date:	#####	Report Date:	10/13/2010	Barrier #:	591
Location:	Brockwood Wy and Annwood Ct - Corner C				
X Coordinate:	-121.31964				
Y Coordinate:	38.71079				
Barrier Area:	Curb Ramps				
Barrier Type:	No Curb Ramp - Depressed Exsiting Curb				
Code Ref:	CBC 1127B.5.1 and ADA/ABA 402.2

As Built Meas:	1	Quantity:	EACH
Description:	No compliant curb cut at corner (intersection)		
As Built Desc:	9.3% running slope at depressed area		
Solution:	Demolish existing and construct curb cut		
Bar. Severity:	1 Necessary	Cost Estimate:	\$2,500.00
Implementation Priority:	4	Facility Function:	
Implementation Phase:		Implementation Date:	
Official Responsible:			
Notes:	Two - way intersection corners B,C

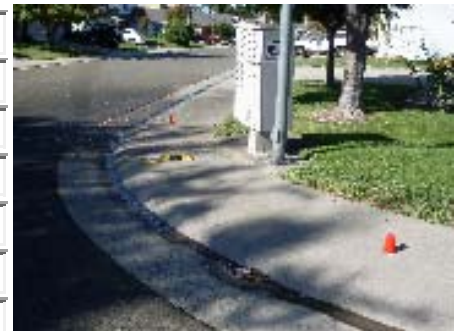
Field Date:	#####	Report Date:	10/13/2010	Barrier #:	592
Location:	Annwood Ct - North				
X Coordinate:	-121.31862				
Y Coordinate:	38.71075				
Barrier Area:	Sidewalks				
Barrier Type:	Cross Slope - Existing (5.0% or more)				
Code Ref:	CBC 1133B.7.1.3 and ADA/ABA 403.3

As Built Meas:	21	Quantity:	LF
Description:	Cross slope exceeds 2.0% (5.0% or more)		
As Built Desc:	5.5% cross slope		
Solution:	Demolish existing and construct new route		
Bar. Severity:	1 Necessary	Cost Estimate:	\$2,625.00
Implementation Priority:	1	Facility Function:	
Implementation Phase:		Implementation Date:	
Official Responsible:			
Notes:

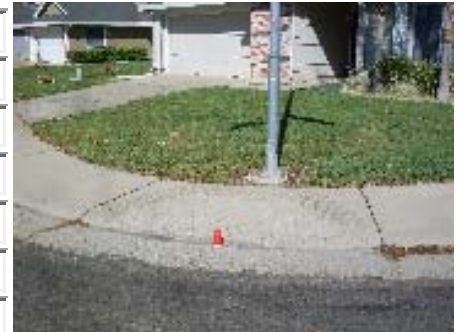
Field Date:	#####	Report Date:	10/13/2010	Barrier #:	593
Location:	Brockwood Wy and Ebonywood Ct - Corner A				
X Coordinate:	-121.31934				
Y Coordinate:	38.71118				
Barrier Area:	Curb Ramps				
Barrier Type:	No Curb Ramp - Depressed Exsiting Curb				
Code Ref:	CBC 1127B.5.1 and ADA/ABA 402.2

As Built Meas:	1	Quantity:	EACH
Description:	No compliant curb cut at corner (intersection)		
As Built Desc:	10.2% running slope at depressed area		
Solution:	Demolish existing and construct curb cut		
Bar. Severity:	1 Necessary	Cost Estimate:	\$2,500.00
Implementation Priority:	4	Facility Function:	
Implementation Phase:		Implementation Date:	
Official Responsible:			
Notes:	Two - way intersection corners A,D

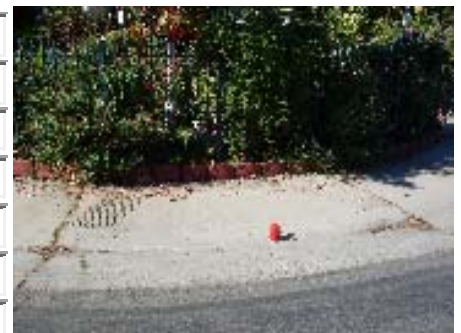
Field Date:	#####	Report Date:	10/13/2010	Barrier #:	594
Location:	Brockwood Wy and Ebonywood Ct - Corner D				
X Coordinate:	-121.31948				
Y Coordinate:	38.71109				
Barrier Area:	Curb Ramps				
Barrier Type:	No Curb Ramp - Depressed Exsiting Curb				
Code Ref:	CBC 1127B.5.1 and ADA/ABA 402.2

As Built Meas:	1	Quantity:	EACH
Description:	No compliant curb cut at corner (intersection)		
As Built Desc:	11.2% running slope at depressed area		
Solution:	Demolish existing and construct curb cut		
Bar. Severity:	1 Necessary	Cost Estimate:	\$2,500.00
Implementation Priority:	4	Facility Function:	
Implementation Phase:		Implementation Date:	
Official Responsible:			
Notes:	Two - way intersection corners A,D

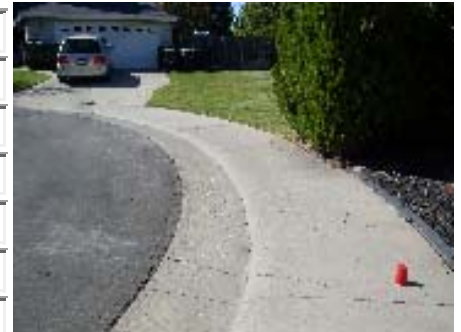
Field Date:	#####	Report Date:	10/13/2010	Barrier #:	595
Location:	Ebonywood Ct - South				
X Coordinate:	-121.32078				
Y Coordinate:	38.71150				
Barrier Area:	Sidewalks				
Barrier Type:	Cross Slope - Existing (4.1% to 4.9%)				
Code Ref:	CBC 1133B.7.1.3 and ADA/ABA 403.3

As Built Meas:	472	Quantity:	LF
Description:	Cross slope exceeds 2.0% (4.1% to 4.9%)		
As Built Desc:	4.7% cross slope		
Solution:	Demolish existing and construct new route		
Bar. Severity:	2 Recommended	Cost Estimate:	\$59,000.00
Implementation Priority:	4	Facility Function:	
Implementation Phase:		Implementation Date:	
Official Responsible:			
Notes:

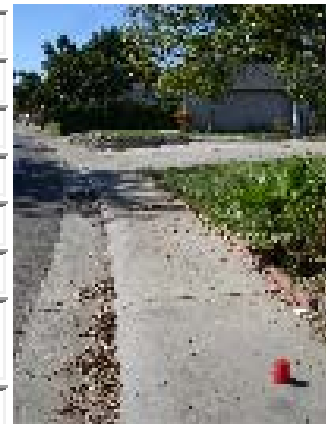
Field Date:	#####	Report Date:	10/13/2010	Barrier #:	596
Location:	Brockwood Wy - West				
X Coordinate:	-121.32076				
Y Coordinate:	38.71090				
Barrier Area:	Sidewalks				
Barrier Type:	Cross Slope - Existing (5.0% or more)				
Code Ref:	CBC 1133B.7.1.3 and ADA/ABA 403.3

As Built Meas:	182	Quantity:	LF
Description:	Cross slope exceeds 2.0% (5.0% or more)		
As Built Desc:	6.4% cross slope		
Solution:	Demolish existing and construct new route		
Bar. Severity:	1 Necessary	Cost Estimate:	\$22,750.00
Implementation Priority:	4	Facility Function:	
Implementation Phase:		Implementation Date:	
Official Responsible:			
Notes:

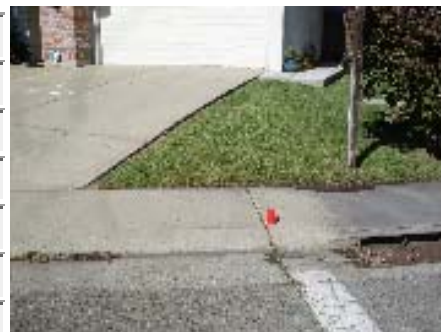
Field Date:	#####	Report Date:	10/13/2010	Barrier #:	597
Location:	Brockwood Wy - West				
X Coordinate:	-121.32163				
Y Coordinate:	38.71041				
Barrier Area:	Curb Ramps				
Barrier Type:	No Curb Ramp				
Code Ref:	CBC 1127B.5.1 and ADA/ABA 402.2

As Built Meas:	1	Quantity:	EACH
Description:	No curb cut at corner (intersection)		
As Built Desc:	No curb ramp at corner		
Solution:	Demolish existing and construct curb cut		
Bar. Severity:	1 Necessary	Cost Estimate:	\$2,500.00
Implementation Priority:	4	Facility Function:	
Implementation Phase:		Implementation Date:	
Official Responsible:

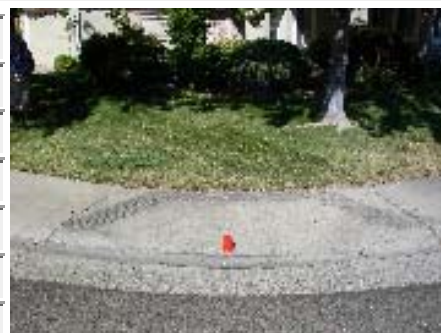
Field Date:	#####	Report Date:	10/13/2010	Barrier #:	598
Location:	Brockwood Wy and Softwood Ct - Corner A				
X Coordinate:	-121.32275				
Y Coordinate:	38.70931				
Barrier Area:	Curb Ramps				
Barrier Type:	No Curb Ramp - Depressed Existing Curb				
Code Ref:	CBC 1127B.5.1 and ADA/ABA 402.2

As Built Meas:	1	Quantity:	EACH
Description:	No compliant curb cut at corner (intersection)		
As Built Desc:	9.9% running slope at depressed area		
Solution:	Demolish existing and construct curb cut		
Bar. Severity:	1 Necessary	Cost Estimate:	\$2,500.00
Implementation Priority:	4	Facility Function:	
Implementation Phase:		Implementation Date:	
Official Responsible:

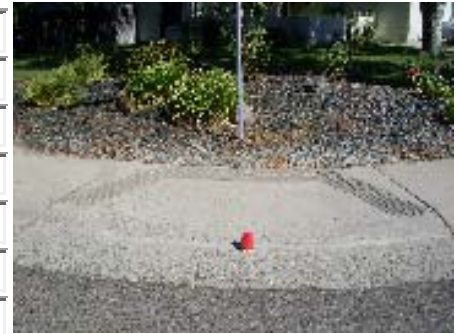
Field Date:	#####	Report Date:	10/13/2010	Barrier #:	599
Location:	Brockwood Wy and Softwood Ct - Corner B				
X Coordinate:	-121.32257				
Y Coordinate:	38.70931				
Barrier Area:	Curb Ramps				
Barrier Type:	No Curb Ramp - Depressed Exsiting Curb				
Code Ref:	CBC 1127B.5.1 and ADA/ABA 402.2

As Built Meas:	1	Quantity:	EACH
Description:	No compliant curb cut at corner (intersection)		
As Built Desc:	11.2% running slope at depressed area		
Solution:	Demolish existing and construct curb cut		
Bar. Severity:	1 Necessary	Cost Estimate:	\$2,500.00
Implementation Priority:	4	Facility Function:	
Implementation Phase:		Implementation Date:	
Official Responsible:			
Notes:	Four - way intersection corners A,B,C,D

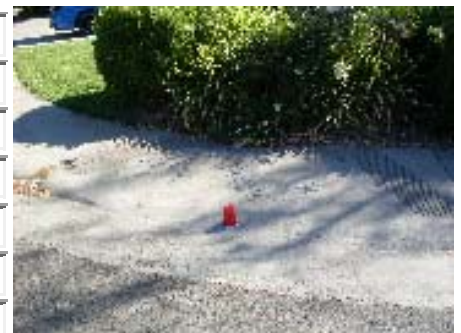
Field Date:	#####	Report Date:	10/13/2010	Barrier #:	600
Location:	Brockwood Wy and Softwood Ct - Corner C				
X Coordinate:	-121.32270				
Y Coordinate:	38.70913				
Barrier Area:	Curb Ramps				
Barrier Type:	No Curb Ramp - Depressed Exsiting Curb				
Code Ref:	CBC 1127B.5.1 and ADA/ABA 402.2

As Built Meas:	1	Quantity:	EACH
Description:	No compliant curb cut at corner (intersection)		
As Built Desc:	11.3% running slope at depressed area		
Solution:	Demolish existing and construct curb cut		
Bar. Severity:	1 Necessary	Cost Estimate:	\$2,500.00
Implementation Priority:	4	Facility Function:	
Implementation Phase:		Implementation Date:	
Official Responsible:			
Notes:	Four - way intersection corners A,B,C,D

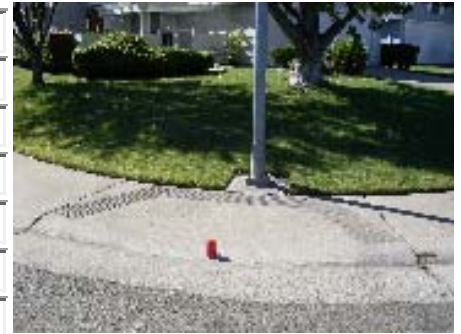
Field Date:	#####	Report Date:	10/13/2010	Barrier #:	601
Location:	Brockwood Wy and Softwood Ct - Corner D				
X Coordinate:	-121.32283				
Y Coordinate:	38.70921				
Barrier Area:	Curb Ramps				
Barrier Type:	No Curb Ramp - Depressed Exsiting Curb				
Code Ref:	CBC 1127B.5.1 and ADA/ABA 402.2

As Built Meas:	1	Quantity:	EACH
Description:	No compliant curb cut at corner (intersection)		
As Built Desc:	9.1% running slope at depressed area		
Solution:	Demolish existing and construct curb cut		
Bar. Severity:	1 Necessary	Cost Estimate:	\$2,500.00
Implementation Priority:	4	Facility Function:	
Implementation Phase:		Implementation Date:	
Official Responsible:			
Notes:	Four - way intersection corners A,B,C,D

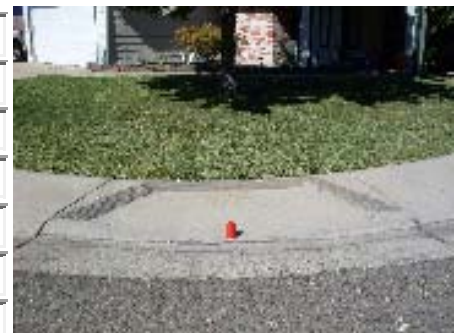
Field Date:	#####	Report Date:	10/13/2010	Barrier #:	602
Location:	Brockwood Wy and Covewood Ct - Corner A				
X Coordinate:	-121.32290				
Y Coordinate:	38.70860				
Barrier Area:	Curb Ramps				
Barrier Type:	No Curb Ramp - Depressed Exsiting Curb				
Code Ref:	CBC 1127B.5.1 and ADA/ABA 402.2

As Built Meas:	1	Quantity:	EACH
Description:	No compliant curb cut at corner (intersection)		
As Built Desc:	11.1% running slope at depressed area		
Solution:	Demolish existing and construct curb cut		
Bar. Severity:	1 Necessary	Cost Estimate:	\$2,500.00
Implementation Priority:	4	Facility Function:	
Implementation Phase:		Implementation Date:	
Official Responsible:			
Notes:	Four - way intersection corners A,B,C,D

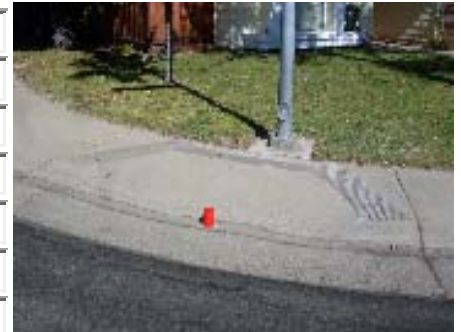
Field Date:	#####	Report Date:	10/13/2010	Barrier #:	603
Location:	Brockwood Wy and Covewood Ct - Corner B				
X Coordinate:	-121.32276				
Y Coordinate:	38.70859				
Barrier Area:	Curb Ramps				
Barrier Type:	No Curb Ramp - Depressed Exsiting Curb				
Code Ref:	CBC 1127B.5.1 and ADA/ABA 402.2

As Built Meas:	1	Quantity:	EACH		
Description:	No compliant curb cut at corner (intersection)				
As Built Desc:	11.2% running slope at depressed area				
Solution:	Demolish existing and construct curb cut				
Bar. Severity:	1 Necessary	Cost Estimate:	\$2,500.00	Status:	
Implementation Priority:	4	Facility Function:			
Implementation Phase:		Implementation Date:			
Official Responsible:					
Notes:	Four - way intersection corners A,B,C,D

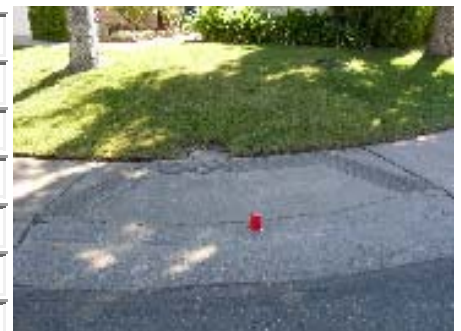
Field Date:	#####	Report Date:	10/13/2010	Barrier #:	604
Location:	Brockwood Wy and Covewood Ct - Corner C				
X Coordinate:	-121.32276				
Y Coordinate:	38.70843				
Barrier Area:	Curb Ramps				
Barrier Type:	No Curb Ramp - Depressed Exsiting Curb				
Code Ref:	CBC 1127B.5.1 and ADA/ABA 402.2

As Built Meas:	1	Quantity:	EACH		
Description:	No compliant curb cut at corner (intersection)				
As Built Desc:	11.0% running slope at depressed area				
Solution:	Demolish existing and construct curb cut				
Bar. Severity:	1 Necessary	Cost Estimate:	\$2,500.00	Status:	
Implementation Priority:	4	Facility Function:			
Implementation Phase:		Implementation Date:			
Official Responsible:					
Notes:	Four - way intersection corners A,B,C,D

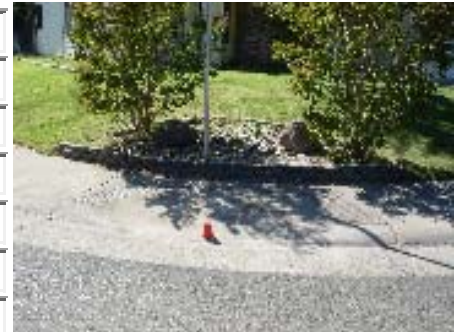
Field Date:	#####	Report Date:	10/13/2010	Barrier #:	605
Location:	Brockwood Wy and Covewood Ct - Corner D				
X Coordinate:	-121.32293				
Y Coordinate:	38.70847				
Barrier Area:	Curb Ramps				
Barrier Type:	No Curb Ramp - Depressed Exsiting Curb				
Code Ref:	CBC 1127B.5.1 and ADA/ABA 402.2

As Built Meas:	1	Quantity:	EACH
Description:	No compliant curb cut at corner (intersection)		
As Built Desc:	9.0% running slope at depressed area		
Solution:	Demolish existing and construct curb cut		
Bar. Severity:	1 Necessary	Cost Estimate:	\$2,500.00
Implementation Priority:	4	Facility Function:	
Implementation Phase:		Implementation Date:	
Official Responsible:			
Notes:	Four - way intersection corners A,B,C,D

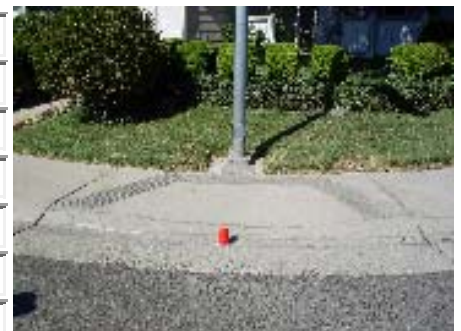
Field Date:	#####	Report Date:	10/13/2010	Barrier #:	606
Location:	Brockwood Wy and Stonehand Ave - Corner A				
X Coordinate:	-121.32289				
Y Coordinate:	38.70790				
Barrier Area:	Curb Ramps				
Barrier Type:	No Curb Ramp - Depressed Exsiting Curb				
Code Ref:	CBC 1127B.5.1 and ADA/ABA 402.2

As Built Meas:	1	Quantity:	EACH
Description:	No compliant curb cut at corner (intersection)		
As Built Desc:	13.2% running slope at depressed area		
Solution:	Demolish existing and construct curb cut		
Bar. Severity:	1 Necessary	Cost Estimate:	\$2,500.00
Implementation Priority:	4	Facility Function:	
Implementation Phase:		Implementation Date:	
Official Responsible:			
Notes:	Two - way intersection corners A,B

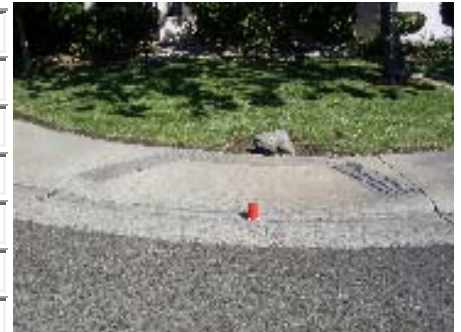
Field Date:	#####	Report Date:	10/13/2010	Barrier #:	607
Location:	Brockwood Wy and Stonehand Ave - Corner B				
X Coordinate:	-121.32266				
Y Coordinate:	38.70791				
Barrier Area:	Curb Ramps				
Barrier Type:	No Curb Ramp - Depressed Exsiting Curb				
Code Ref:	CBC 1127B.5.1 and ADA/ABA 402.2

As Built Meas:	1	Quantity:	EACH
Description:	No compliant curb cut at corner (intersection)		
As Built Desc:	8.9% running slope at depressed area		
Solution:	Demolish existing and construct curb cut		
Bar. Severity:	1 Necessary	Cost Estimate:	\$2,500.00
Implementation Priority:	4	Facility Function:	
Implementation Phase:		Implementation Date:	
Official Responsible:			
Notes:	Two - way intersection corners A,B

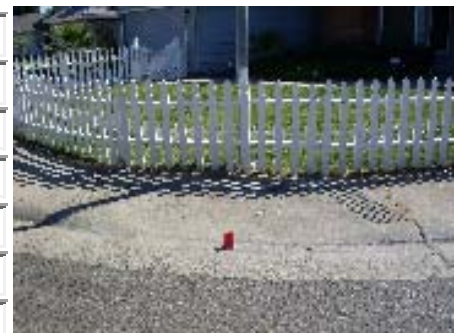
Field Date:	#####	Report Date:	10/13/2010	Barrier #:	608
Location:	Stonehand Ave and Lonewood Wy - Corner C				
X Coordinate:	-121.32403				
Y Coordinate:	38.70770				
Barrier Area:	Curb Ramps				
Barrier Type:	No Curb Ramp - Depressed Exsiting Curb				
Code Ref:	CBC 1127B.5.1 and ADA/ABA 402.2

As Built Meas:	1	Quantity:	EACH
Description:	No compliant curb cut at corner (intersection)		
As Built Desc:	10.3% running slope at depressed area		
Solution:	Demolish existing and construct curb cut		
Bar. Severity:	1 Necessary	Cost Estimate:	\$2,500.00
Implementation Priority:	4	Facility Function:	
Implementation Phase:		Implementation Date:	
Official Responsible:			
Notes:	Two - way intersection corners C,D

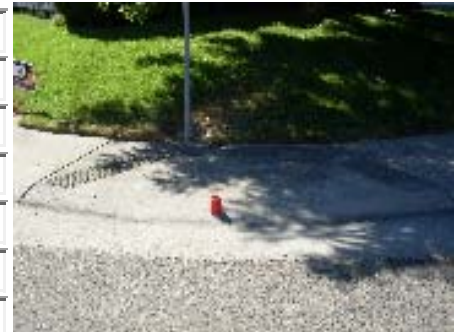
Field Date:	#####	Report Date:	10/13/2010	Barrier #:	609
Location:	Stonehand Ave and Lonewood Wy - Corner D				
X Coordinate:	-121.32424				
Y Coordinate:	38.70775				
Barrier Area:	Curb Ramps				
Barrier Type:	No Curb Ramp - Depressed Exsiting Curb				
Code Ref:	CBC 1127B.5.1 and ADA/ABA 402.2

As Built Meas:	1	Quantity:	EACH
Description:	No compliant curb cut at corner (intersection)		
As Built Desc:	9.9% running slope at depressed area		
Solution:	Demolish existing and construct curb cut		
Bar. Severity:	1 Necessary	Cost Estimate:	\$2,500.00
Implementation Priority:	4	Facility Function:	
Implementation Phase:		Implementation Date:	
Official Responsible:			
Notes:	Two - way intersection corners C,D

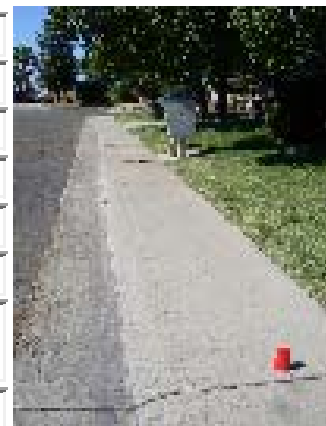
Field Date:	#####	Report Date:	10/13/2010	Barrier #:	610
Location:	Geoffwodd Ct - North				
X Coordinate:	-121.32422				
Y Coordinate:	38.70791				
Barrier Area:	Sidewalks				
Barrier Type:	Cross Slope - Existing (5.0% or more)				
Code Ref:	CBC 1133B.7.1.3 and ADA/ABA 403.3

As Built Meas:	208	Quantity:	LF
Description:	Cross slope exceeds 2.0% (5.0% or more)		
As Built Desc:	5.0% cross slope		
Solution:	Demolish existing and construct new route		
Bar. Severity:	1 Necessary	Cost Estimate:	\$26,000.00
Implementation Priority:	4	Facility Function:	
Implementation Phase:		Implementation Date:	
Official Responsible:			
Notes:

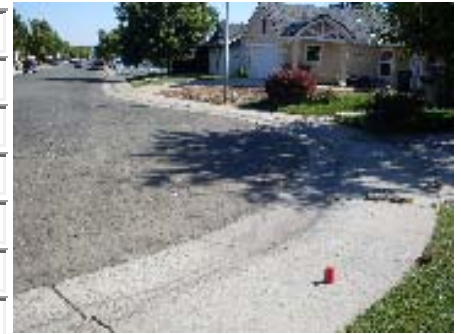
Field Date:	#####	Report Date:	10/13/2010	Barrier #:	611
Location:	Geoffwodd Ct - South				
X Coordinate:	-121.32476				
Y Coordinate:	38.70777				
Barrier Area:	Sidewalks				
Barrier Type:	Cross Slope - Existing (5.0% or more)				
Code Ref:	CBC 1133B.7.1.3 and ADA/ABA 403.3

As Built Meas:	166	Quantity:	LF
Description:	Cross slope exceeds 2.0% (5.0% or more)		
As Built Desc:	5.6% cross slope		
Solution:	Demolish existing and construct new route		
Bar. Severity:	1 Necessary	Cost Estimate:	\$20,750.00
Implementation Priority:	4	Facility Function:	
Implementation Phase:		Implementation Date:	
Official Responsible:

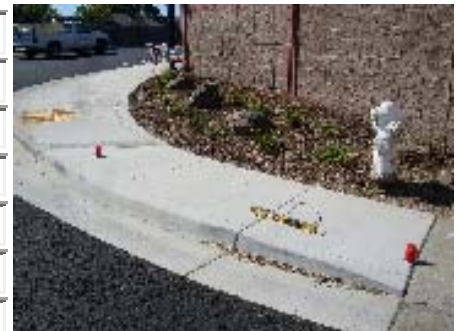
Field Date:	#####	Report Date:	10/13/2010	Barrier #:	612
Location:	Lonewood Wy - West				
X Coordinate:	-121.32423				
Y Coordinate:	38.70774				
Barrier Area:	Sidewalks				
Barrier Type:	Running Slope (Existing)				
Code Ref:	CBC 1133B.7.3 and ADA/ABA 403.3

As Built Meas:	8	Quantity:	LF
Description:	Running slope exceeds 5.0%		
As Built Desc:	10.7% running slope		
Solution:	No remediation where sidewalk sloped as roadway		
Bar. Severity:	5 Technically Infeasible	Cost Estimate:	\$0.00
Implementation Priority:	4	Facility Function:	
Implementation Phase:		Implementation Date:	
Official Responsible:

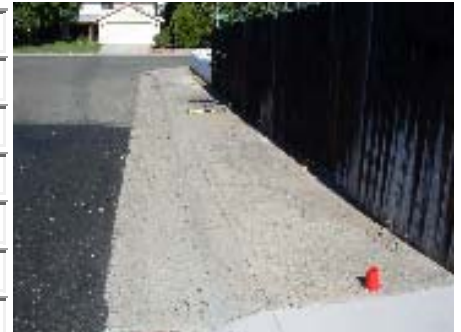
Field Date:	#####	Report Date:	10/13/2010	Barrier #:	613
Location:	Lonewood Wy - East				
X Coordinate:	-121.32404				
Y Coordinate:	38.70751				
Barrier Area:	Sidewalks				
Barrier Type:	Cross Slope - Existing (4.1% to 4.9%)				
Code Ref:	CBC 1133B.7.1.3 and ADA/ABA 403.3

As Built Meas:	52	Quantity:	LF
Description:	Cross slope exceeds 2.0% (4.1% to 4.9%)		
As Built Desc:	4.8% cross slope		
Solution:	Demolish existing and construct new route		
Bar. Severity:	2 Recommended	Cost Estimate:	\$6,500.00
Implementation Priority:	4	Facility Function:	
Implementation Phase:		Implementation Date:	
Official Responsible:			
Notes:

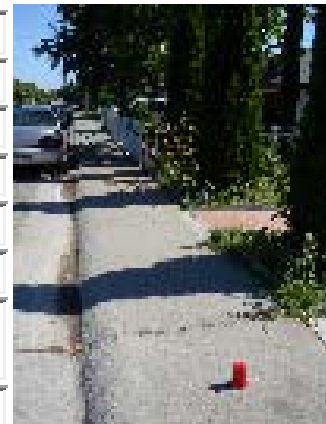
Field Date:	#####	Report Date:	10/13/2010	Barrier #:	614
Location:	Stonehead Ave - South				
X Coordinate:	-121.32400				
Y Coordinate:	38.70775				
Barrier Area:	Sidewalks				
Barrier Type:	Cross Slope - Existing (4.1% to 4.9%)				
Code Ref:	CBC 1133B.7.1.3 and ADA/ABA 403.3

As Built Meas:	30	Quantity:	LF
Description:	Cross slope exceeds 2.0% (4.1% to 4.9%)		
As Built Desc:	4.6% cross slope		
Solution:	Demolish existing and construct new route		
Bar. Severity:	2 Recommended	Cost Estimate:	\$3,750.00
Implementation Priority:	4	Facility Function:	
Implementation Phase:		Implementation Date:	
Official Responsible:			
Notes:

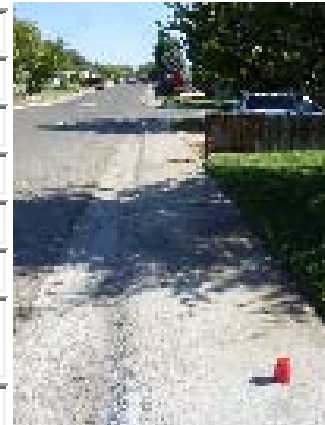
Barrier Type: Cross Slope - Existing (5.0% or more)

As Built Meas: 88 Quantity: LF

Description: Cross slope exceeds 2.0% (5.0% or more)

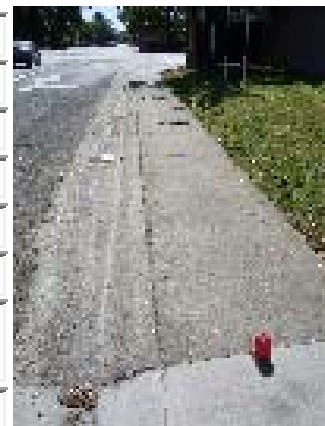
Barrier Type: Cross Slope - Existing (5.0% or more)

As Built Meas: 90 Quantity: LF

Description: Cross slope exceeds 2.0% (5.0% or more)

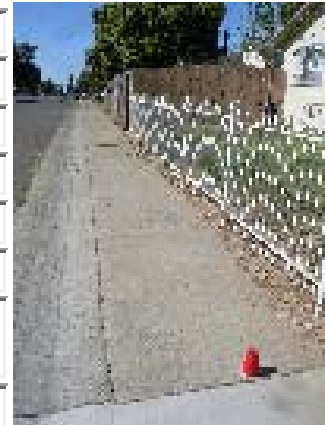
Barrier Type: Cross Slope - Existing (5.0% or more)

As Built Meas: 109 Quantity: LF

Description: Cross slope exceeds 2.0% (5.0% or more)

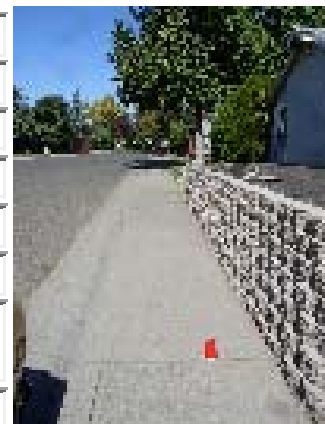
Barrier Type: Cross Slope - Existing (5.0% or more)

As Built Meas: 78 Quantity: LF

Description: Cross slope exceeds 2.0% (5.0% or more)

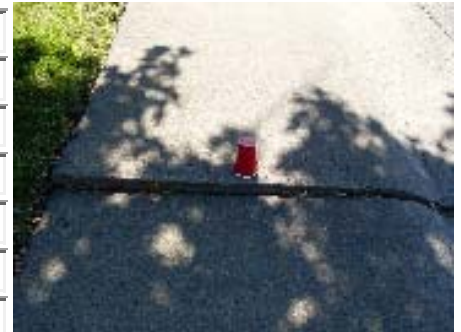
Barrier Type: Abrupt Change in Level - Tree Heaves

As Built Meas: 4 Quantity: LF

Description: Change in level greater than 1/2"

Solution: Grind or repair sidewalk to remove trip hazard

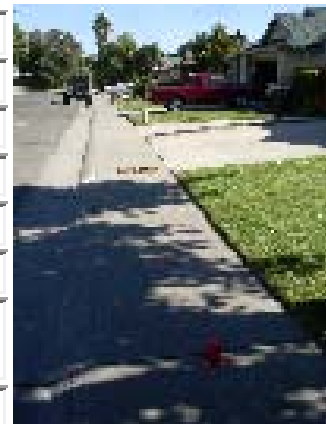
Barrier Type: Cross Slope - Existing (4.1% to 4.9%)

As Built Meas: 327 Quantity: LF

Description: Cross slope exceeds 2.0% (4.1% to 4.9%)

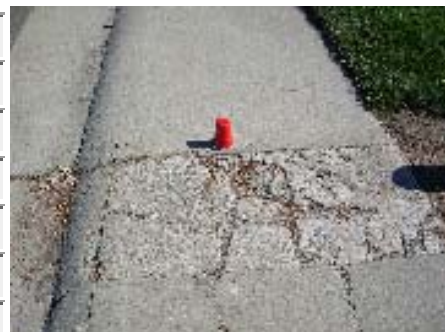
Barrier Type: Surface Condition - Damaged

As Built Meas: 4 Quantity: LF

Description: Surface is not firm and stable (cracked, broken or loose soil, etc.)

As Built Desc: Cracked concrete

Solution: Repair surface to make firm and stable

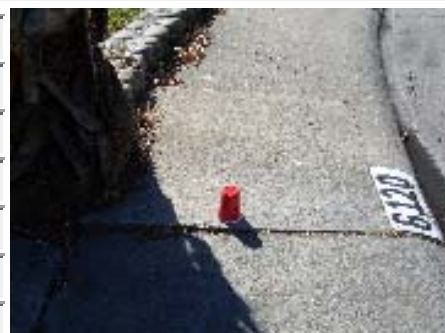
Barrier Type: Abrupt Change in Level - Tree Heaves

As Built Meas: 4 Quantity: LF

Description: Change in level greater than 1/2"

Solution: Grind or repair sidewalk to remove trip hazard

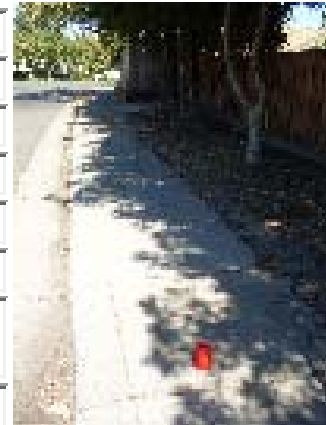
Field Date:	#####	Report Date:	10/13/2010	Barrier #:	620
Location:	Brockwood Wy - East				
X Coordinate:	-121.32276				
Y Coordinate:	38.70864				
Barrier Area:	Sidewalks				
Barrier Type:	Cross Slope - Existing (5.0% or more)				
Code Ref:	CBC 1133B.7.1.3 and ADA/ABA 403.3

As Built Meas:	144	Quantity:	LF
Description:	Cross slope exceeds 2.0% (5.0% or more)		
As Built Desc:	5.5% cross slope		
Solution:	Demolish existing and construct new route		
Bar. Severity:	1 Necessary	Cost Estimate:	\$18,000.00
Implementation Priority:	4	Facility Function:	
Implementation Phase:		Implementation Date:	
Official Responsible:

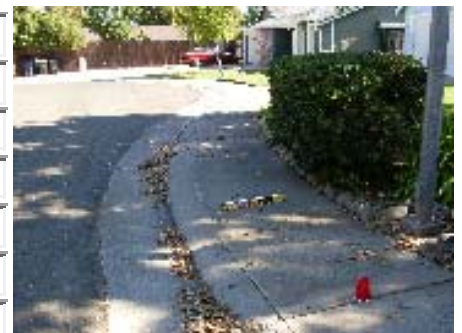
Field Date:	#####	Report Date:	10/13/2010	Barrier #:	621
Location:	Softwood Ct - South				
X Coordinate:	-121.32267				
Y Coordinate:	38.70915				
Barrier Area:	Sidewalks				
Barrier Type:	Cross Slope - Existing (5.0% or more)				
Code Ref:	CBC 1133B.7.1.3 and ADA/ABA 403.3

As Built Meas:	45	Quantity:	LF
Description:	Cross slope exceeds 2.0% (5.0% or more)		
As Built Desc:	5.0% cross slope		
Solution:	Demolish existing and construct new route		
Bar. Severity:	1 Necessary	Cost Estimate:	\$5,625.00
Implementation Priority:	4	Facility Function:	
Implementation Phase:		Implementation Date:	
Official Responsible:
