DRAFT ADA TRANSITION PLAN UPDATE
NEIGHBORHOOD AREA 1 NORTHWEST
SEPTEMBER 20, 2011

CITY OF CITRUS HEIGHTS

The Northwest Neighborhood Association

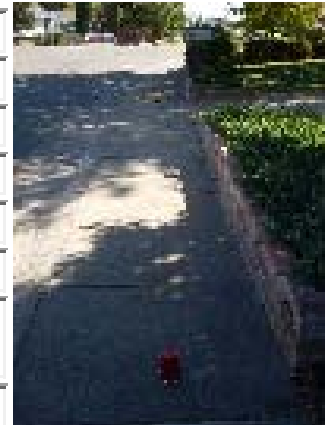
Field Date:	#####	Report Date:	10/13/2010	Barrier #:	622
Location:	Saybrook Dr - West				
X Coordinate:	-121.32175				
Y Coordinate:	38.71016				
Barrier Area:	Sidewalks				
Barrier Type:	Cross Slope - Existing (5.0% or more)				
Code Ref:	CBC 1133B.7.1.3 and ADA/ABA 403.3				
As Built Meas:	790	Quantity:	LF		
Description:	Cross slope exceeds 2.0% (5.0% or more)				
As Built Desc:	5.7% cross slope				
Solution:	Demolish existing and construct new route				
Bar. Severity:	1 Necessary	Cost Estimate:	\$98,750.00	Status:	
Implementation Priority:	4	Facility Function:			
Implementation Phase:		Implementation Date:			
Official Responsible:					
Notes:

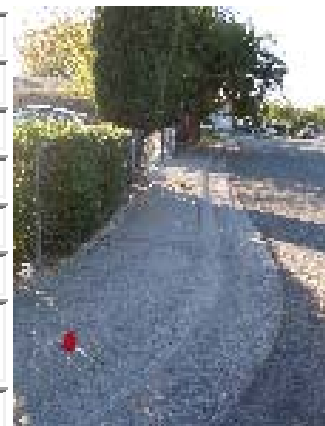
Field Date:	#####	Report Date:	10/14/2010	Barrier #:	623
Location:	Saybrook Dr - East				
X Coordinate:	-121.32110				
Y Coordinate:	38.70977				
Barrier Area:	Sidewalks				
Barrier Type:	Cross Slope - Existing (5.0% or more)				
Code Ref:	CBC 1133B.7.1.3 and ADA/ABA 403.3				
As Built Meas:	157	Quantity:	LF		
Description:	Cross slope exceeds 2.0% (5.0% or more)				
As Built Desc:	5.7% cross slope				
Solution:	Demolish existing and construct new route				
Bar. Severity:	1 Necessary	Cost Estimate:	\$19,625.00	Status:	
Implementation Priority:	4	Facility Function:			
Implementation Phase:		Implementation Date:			
Official Responsible:					
Notes:

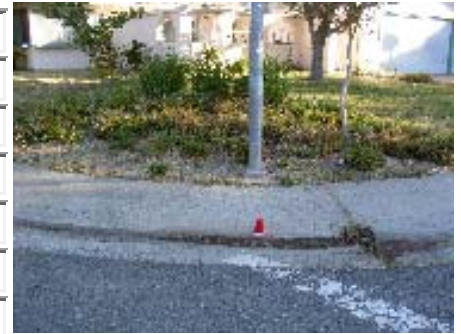
Field Date:	#####	Report Date:	10/14/2010	Barrier #:	624
Location:	Saybrook Dr and Graystone Ave - Corner B				
X Coordinate:	-121.32092				
Y Coordinate:	38.70934				
Barrier Area:	Curb Ramps				
Barrier Type:	No Curb Ramp - Depressed Exsiting Curb				
Code Ref:	CBC 1127B.5.1 and ADA/ABA 402.2

As Built Meas:	1	Quantity:	EACH		
Description:	No compliant curb cut at corner (intersection)				
As Built Desc:	8.4% running slope at depressed area				
Solution:	Demolish existing and construct curb cut				
Bar. Severity:	1 Necessary	Cost Estimate:	\$2,500.00	Status:	
Implementation Priority:	4	Facility Function:			
Implementation Phase:		Implementation Date:			
Official Responsible:					
Notes:	Two - way intersection corners B,C

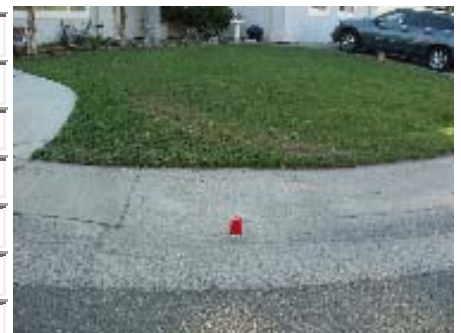
Field Date:	#####	Report Date:	10/14/2010	Barrier #:	625
Location:	Saybrook Dr and Graystone Ave - Corner C				
X Coordinate:	-121.32088				
Y Coordinate:	38.70922				
Barrier Area:	Curb Ramps				
Barrier Type:	No Curb Ramp - Depressed Exsiting Curb				
Code Ref:	CBC 1127B.5.1 and ADA/ABA 402.2

As Built Meas:	1	Quantity:	EACH		
Description:	No compliant curb cut at corner (intersection)				
As Built Desc:	8.3% running slope at depressed area				
Solution:	Demolish existing and construct curb cut				
Bar. Severity:	1 Necessary	Cost Estimate:	\$2,500.00	Status:	
Implementation Priority:	4	Facility Function:			
Implementation Phase:		Implementation Date:			
Official Responsible:					
Notes:	Two - way intersection corners B,C

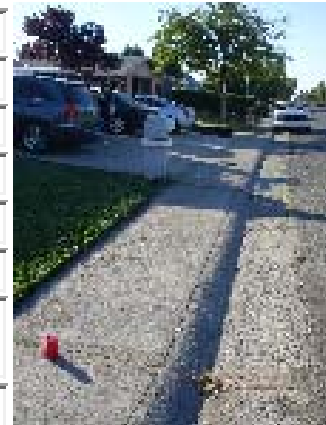
Barrier Type: Cross Slope - Existing (5.0% or more)

As Built Meas: 188 Quantity: LF

Description: Cross slope exceeds 2.0% (5.0% or more)

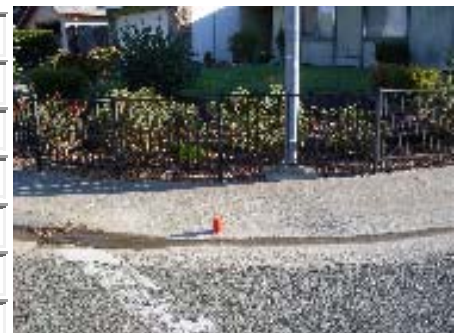
Barrier Type: No Curb Ramp - Depressed Existing Curb

As Built Meas: 1 Quantity: EACH

Description: No compliant curb cut at corner (intersection)

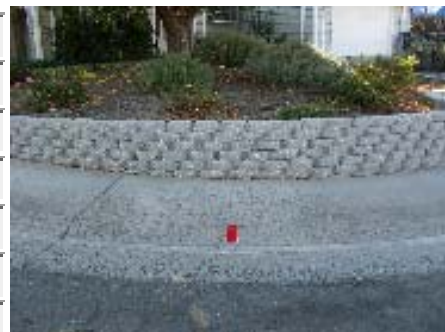
Barrier Type: No Curb Ramp - Depressed Exsiting Curb

As Built Meas: 1 Quantity: EACH

Description: No compliant curb cut at corner (intersection)

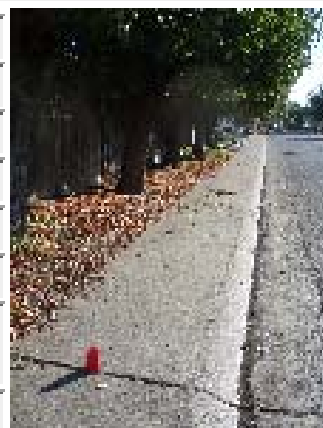
Barrier Type: Cross Slope - Existing (5.0% or more)

As Built Meas: 352 Quantity: LF

Description: Cross slope exceeds 2.0% (5.0% or more)

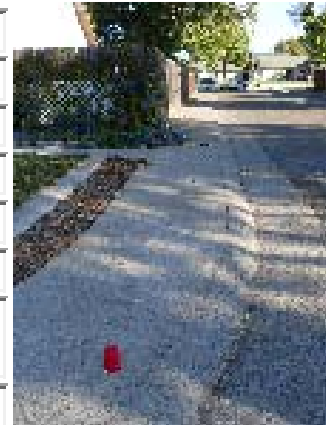
Field Date:	#####	Report Date:	10/14/2010	Barrier #:	630A
Location:	Ledgewood Wy - West				
X Coordinate:	-121.31948				
Y Coordinate:	38.70874				
Barrier Area:	Sidewalks				
Barrier Type:	Cross Slope - Existing (5.0% or more)				
Code Ref:	CBC 1133B.7.1.3 and ADA/ABA 403.3

As Built Meas:	206	Quantity:	LF		
Description:	Cross slope exceeds 2.0% (5.0% or more)				
As Built Desc:	10.2% cross slope				
Solution:	Demolish existing and construct new route				
Bar. Severity:	1 Necessary	Cost Estimate:	\$25,750.00	Status:	
Implementation Priority:	4	Facility Function:			
Implementation Phase:		Implementation Date:			
Official Responsible:

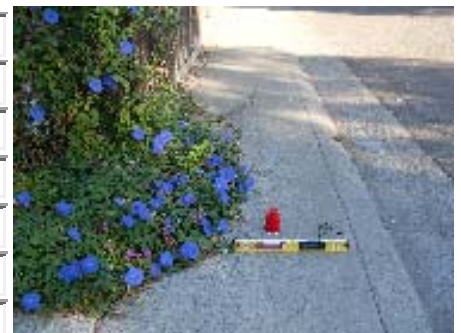
Field Date:	#####	Report Date:	10/14/2010	Barrier #:	630B
Location:	Ledgewood Wy - West				
X Coordinate:	-121.31948				
Y Coordinate:	38.70874				
Barrier Area:	Sidewalks				
Barrier Type:	Clear Width - Existing ($\leq 31"$ or less)				
Code Ref:	CBC 1133B.7.1

As Built Meas:	1	Quantity:	LF		
Description:	Pedestrian route is not min. 48" wide ($\leq 31"$ or less)				
As Built Desc:	24" clear width due to foliage				
Solution:	Trim foliage to provide min. 48" clear width				
Bar. Severity:	1 Necessary	Cost Estimate:	\$125.00	Status:	
Implementation Priority:	4	Facility Function:			
Implementation Phase:		Implementation Date:			
Official Responsible:

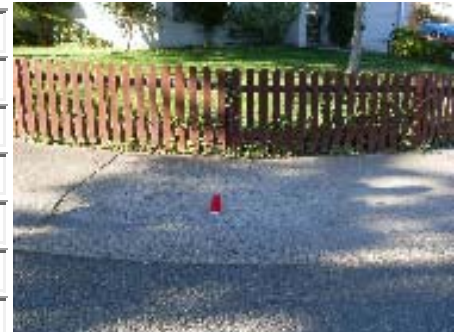
Field Date:	#####	Report Date:	10/14/2010	Barrier #:	631
Location:	Ledgewood Wy and Graystone Ave - Corner D				
X Coordinate:	-121.31952				
Y Coordinate:	38.70921				
Barrier Area:	Curb Ramps				
Barrier Type:	No Curb Ramp - Depressed Exsiting Curb				
Code Ref:	CBC 1127B.5.1 and ADA/ABA 402.2

As Built Meas:	1	Quantity:	EACH
Description:	No compliant curb cut at corner (intersection)		
As Built Desc:	10.3% running slope at depressed area		
Solution:	Demolish existing and construct curb cut		
Bar. Severity:	1 Necessary	Cost Estimate:	\$2,500.00
Implementation Priority:	4	Facility Function:	
Implementation Phase:		Implementation Date:	
Official Responsible:			
Notes:	Two - way intersection corners C,D

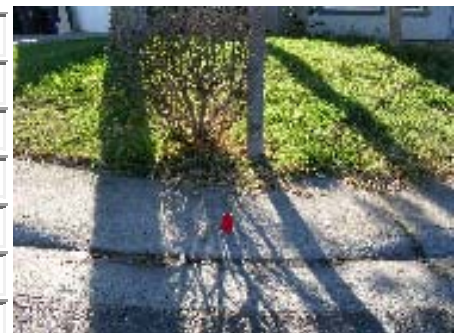
Field Date:	#####	Report Date:	10/14/2010	Barrier #:	632
Location:	Ledgewood Wy and Graystone Ave - Corner C				
X Coordinate:	-121.31936				
Y Coordinate:	38.70922				
Barrier Area:	Curb Ramps				
Barrier Type:	No Curb Ramp - Depressed Exsiting Curb				
Code Ref:	CBC 1127B.5.1 and ADA/ABA 402.2

As Built Meas:	1	Quantity:	EACH
Description:	No compliant curb cut at corner (intersection)		
As Built Desc:	11.1% running slope at depressed area		
Solution:	Demolish existing and construct curb cut		
Bar. Severity:	1 Necessary	Cost Estimate:	\$2,500.00
Implementation Priority:	4	Facility Function:	
Implementation Phase:		Implementation Date:	
Official Responsible:			
Notes:	Two - way intersection corners C,D

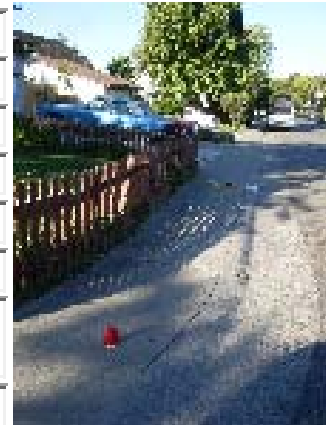
Barrier Type: Cross Slope - Existing (5.0% or more)

As Built Meas: 583 Quantity: LF

Description: Cross slope exceeds 2.0% (5.0% or more)

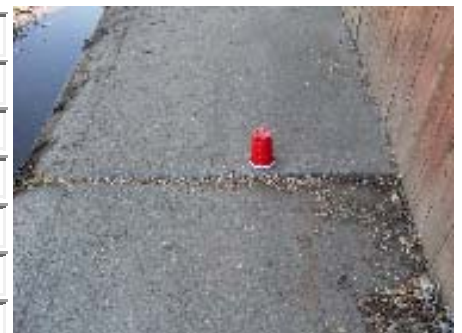
Barrier Type: Abrupt Change in Level - Tree Heaves

As Built Meas: 4 Quantity: LF

Description: Change in level greater than 1/2"

Solution: Grind or repair sidewalk to remove trip hazard

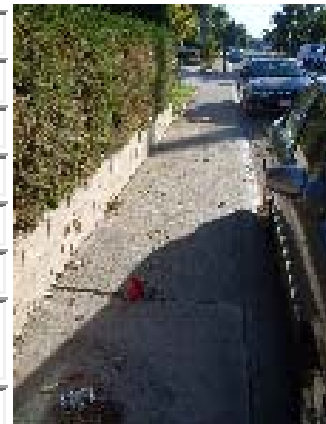
Field Date:	#####	Report Date:	10/14/2010	Barrier #:	634A
Location:	Graystone Ave - North				
X Coordinate:	-121.32084				
Y Coordinate:	38.70932				
Barrier Area:	Sidewalks				
Barrier Type:	Cross Slope - Existing (5.0% or more)				
Code Ref:	CBC 1133B.7.1.3 and ADA/ABA 403.3

As Built Meas:	553	Quantity:	LF
Description:	Cross slope exceeds 2.0% (5.0% or more)		
As Built Desc:	5.2% cross slope		
Solution:	Demolish existing and construct new route		
Bar. Severity:	1 Necessary	Cost Estimate:	\$69,125.00
Implementation Priority:	4	Facility Function:	
Implementation Phase:		Implementation Date:	
Official Responsible:			
Notes:

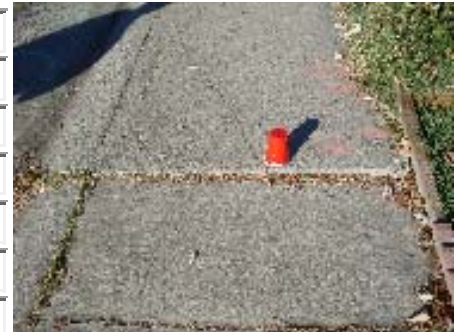
Barrier Type: Abrupt Change in Level - > 1/2"

Code Ref: CBC 1133B.7.1 and ADA/ABA 303.3

As Built Meas: 4 Quantity: LF

Description: Change in level greater than 1/2"

Solution: Grind or repair sidewalk to remove trip hazard

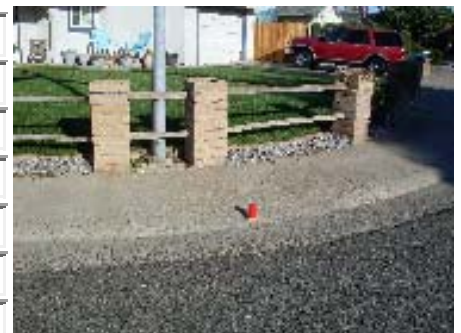
Barrier Type: No Curb Ramp - Depressed Exsiting Curb

Code Ref: CBC 1127B.5.1 and ADA/ABA 402.2

As Built Meas: 1 Quantity: EACH

Description: No compliant curb cut at corner (intersection)

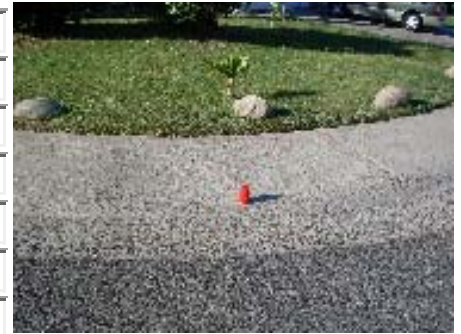
Field Date:	#####	Report Date:	10/14/2010	Barrier #:	636
Location:	Graystone Ave and Ashmont St - Corner D				
X Coordinate:	-121.31862				
Y Coordinate:	38.70921				
Barrier Area:	Curb Ramps				
Barrier Type:	No Curb Ramp - Depressed Exsiting Curb				
Code Ref:	CBC 1127B.5.1 and ADA/ABA 402.2

As Built Meas:	1	Quantity:	EACH
Description:	No compliant curb cut at corner (intersection)		
As Built Desc:	10.7% running slope at depressed area		
Solution:	Demolish existing and construct curb cut		
Bar. Severity:	1 Necessary	Cost Estimate:	\$2,500.00
Implementation Priority:	4	Facility Function:	
Implementation Phase:		Implementation Date:	
Official Responsible:			
Notes:	Two - way intersection corners A,D

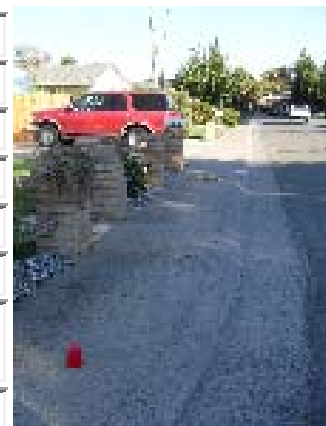
Field Date:	#####	Report Date:	10/14/2010	Barrier #:	637
Location:	Ashmont St - West				
X Coordinate:	-121.31859				
Y Coordinate:	38.70943				
Barrier Area:	Sidewalks				
Barrier Type:	Cross Slope - Existing (5.0% or more)				
Code Ref:	CBC 1133B.7.1.3 and ADA/ABA 403.3

As Built Meas:	192	Quantity:	LF
Description:	Cross slope exceeds 2.0% (5.0% or more)		
As Built Desc:	10.4% cross slope		
Solution:	Demolish existing and construct new route		
Bar. Severity:	1 Necessary	Cost Estimate:	\$24,000.00
Implementation Priority:	4	Facility Function:	
Implementation Phase:		Implementation Date:	
Official Responsible:			
Notes:

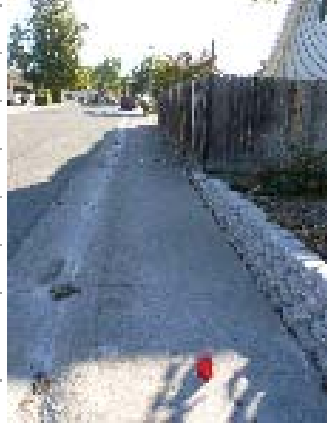
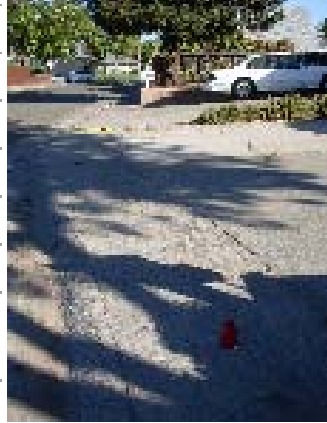
Field Date:	#####	Report Date:	10/14/2010	Barrier #:	640

Location:	Ledgewood Wy - South					
X Coordinate:	-121.32072					
Y Coordinate:	38.70852					
Barrier Area:	Sidewalks					
Barrier Type:	Cross Slope - Existing (5.0% or more)					
Code Ref:	CBC 1133B.7.1.3 and ADA/ABA 403.3					
As Built Meas:	425		Quantity:		LF

Description:	Cross slope exceeds 2.0% (5.0% or more)					
As Built Desc:	8.8% cross slope					
Solution:	Demolish existing and construct new route					
Bar. Severity:	1 Necessary		Cost Estimate:	\$53,125.00	Status:	
Implementation Priority:	4		Facility Function:			
Implementation Phase:			Implementation Date:			
Official Responsible:						
Notes:

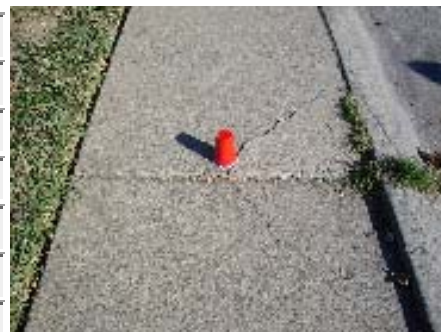
Barrier Type: Surface Condition - Damaged

Code Ref: CBC 1133B.7.1 and ADA/ABA 302.1

As Built Meas: 8 Quantity: LF

Description: Surface is not firm and stable (cracked, broken or loose soil, etc.)

As Built Desc: Cracked concrete

Solution: Repair surface to make firm and stable

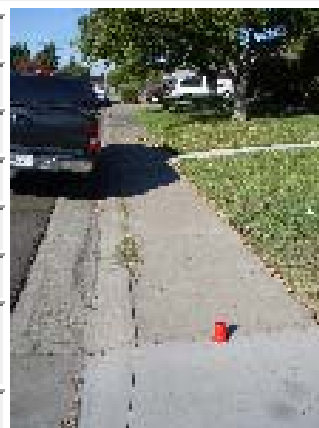
Barrier Type: Cross Slope - Existing (5.0% or more)

Code Ref: CBC 1133B.7.1.3 and ADA/ABA 403.3

As Built Meas: 604 Quantity: LF

Description: Cross slope exceeds 2.0% (5.0% or more)

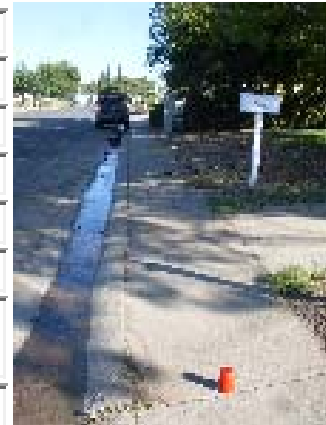
Barrier Type: Cross Slope - Existing (5.0% or more)

Code Ref: CBC 1133B.7.1.3 and ADA/ABA 403.3

As Built Meas: 195 Quantity: LF

Description: Cross slope exceeds 2.0% (5.0% or more)

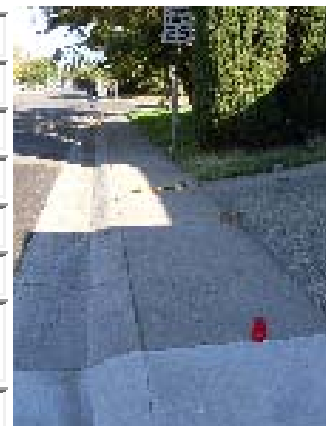
Barrier Type: Cross Slope - Existing (5.0% or more)

Code Ref: CBC 1133B.7.1.3 and ADA/ABA 403.3

As Built Meas: 73 Quantity: LF

Description: Cross slope exceeds 2.0% (5.0% or more)

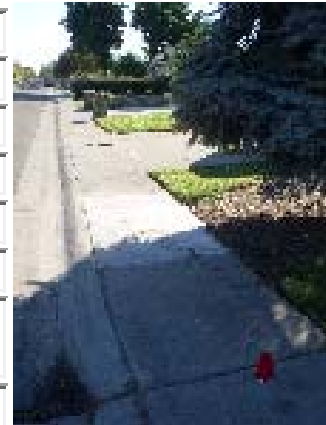
Barrier Type: Cross Slope - Existing (5.0% or more)

Code Ref: CBC 1133B.7.1.3 and ADA/ABA 403.3

As Built Meas: 899 Quantity: LF

Description: Cross slope exceeds 2.0% (5.0% or more)

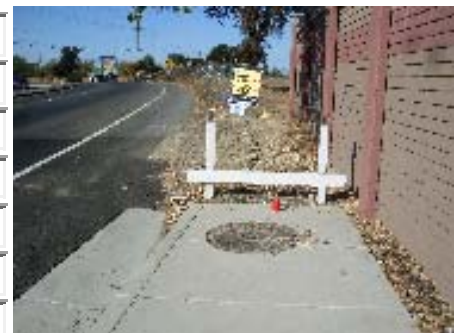
Barrier Type: No sidewalk

Code Ref: CBC 1127B.1 and ADA/ABA 206.2.1

As Built Meas: 95 Quantity: LF

Description: No pedestrian route provided

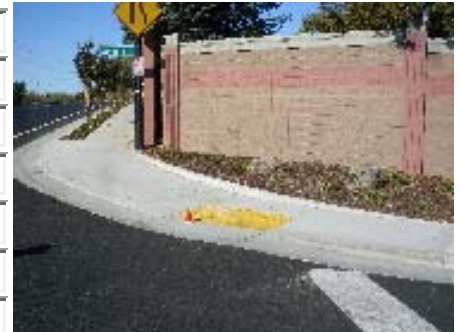
Field Date:	#####	Report Date:	10/14/2010	Barrier #:	649
Location:	Antelope Rd and Lonewood Wy - Corner A				
X Coordinate:	-121.32431				
Y Coordinate:	38.70740				
Barrier Area:	Curb Ramps				
Barrier Type:	12" Grooves - New Construction				
Code Ref:	CBC 1127B.5.6

As Built Meas:	1	Quantity:	EACH
Description:	12" grooves at top of curb ramp are not level (>5.0%)		
As Built Desc:	6.7% at 12" grooves - New Construction		
Solution:	Demolish existing and construct new curb ramp		
Bar. Severity:	1 Necessary	Cost Estimate:	\$2,500.00
Implementation Priority:	1	Facility Function:	
Implementation Phase:		Implementation Date:	
Official Responsible:			
Notes:	Two - way intersection corners A,B. Corner B compliant

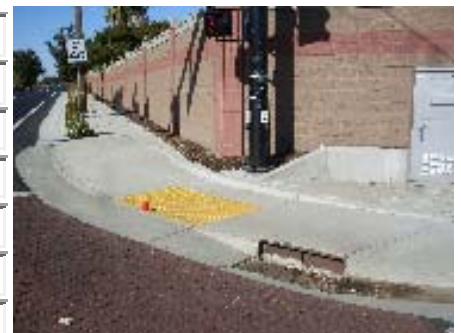
Field Date:	#####	Report Date:	10/14/2010	Barrier #:	650
Location:	Antelope Rd and Saybrook Dr - Corner A				
X Coordinate:	-121.32106				
Y Coordinate:	38.70748				
Barrier Area:	Curb Ramps				
Barrier Type:	12" Grooves - New Construction				
Code Ref:	CBC 1127B.5.6

As Built Meas:	1	Quantity:	EACH
Description:	12" grooves at top of curb ramp are not level (4.1% to 4.9%)		
As Built Desc:	4.3% at 12" grooves - New Construction		
Solution:	Demolish existing and construct new curb ramp		
Bar. Severity:	1 Necessary	Cost Estimate:	\$2,500.00
Implementation Priority:	1	Facility Function:	
Implementation Phase:		Implementation Date:	
Official Responsible:			
Notes:	Four - way intersection corners A,B,C,D. Corner C compliant, Signalized control compliant

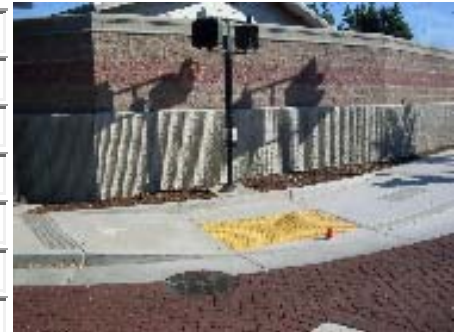
Field Date:	#####	Report Date:	10/14/2010	Barrier #:	651A
Location:	Antelope Rd and Saybrook Dr - Corner B				
X Coordinate:	-121.32082				
Y Coordinate:	38.70748				
Barrier Area:	Curb Ramps				
Barrier Type:	12" Grooves - New Construction				
Code Ref:	CBC 1127B.5.6

As Built Meas:	1	Quantity:	EACH
Description:	12" grooves at top of curb ramp are not level (3.1% to 4.0%)		
As Built Desc:	3.4% at 12" grooves		
Solution:	Demolish existing and construct new curb ramp		
Bar. Severity:	1 Necessary	Cost Estimate:	\$2,500.00
Implementation Priority:	1	Facility Function:	
Implementation Phase:		Implementation Date:	
Official Responsible:			
Notes:	Four - way intersection corners A,B,C,D. Corner C compliant, Signalized control compliant

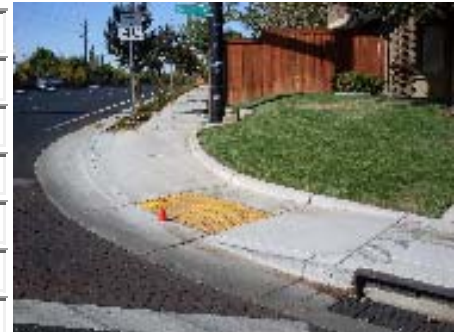
Field Date:	#####	Report Date:	10/14/2010	Barrier #:	652
Location:	Antelope Rd and Saybrook Dr - Corner D				
X Coordinate:	-121.32115				
Y Coordinate:	38.70721				
Barrier Area:	Curb Ramps				
Barrier Type:	12" Grooves - New Construction				
Code Ref:	CBC 1127B.5.6

As Built Meas:	1	Quantity:	EACH
Description:	12" grooves at top of curb ramp are not level (>5.0%)		
As Built Desc:	5.2% at 12" grooves - New Construction		
Solution:	Demolish existing and construct new curb ramp		
Bar. Severity:	1 Necessary	Cost Estimate:	\$2,500.00
Implementation Priority:	1	Facility Function:	
Implementation Phase:		Implementation Date:	
Official Responsible:			
Notes:	Four - way intersection corners A,B,C,D. Corner C compliant, Signalized control compliant

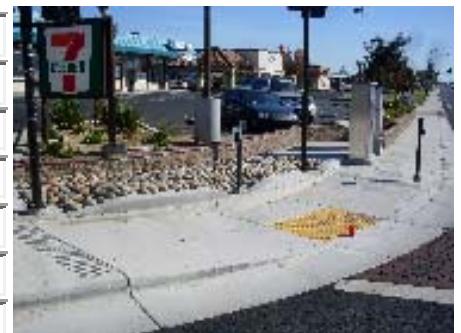
Field Date:	#####	Report Date:	10/14/2010	Barrier #:	653
Location:	Antelope Rd and Zenith Dr - Corner A (A-A)				
X Coordinate:	-121.31558				
Y Coordinate:	38.70753				
Barrier Area:	Curb Ramps				
Barrier Type:	12" Grooves - New Construction				
Code Ref:	CBC 1127B.5.6

As Built Meas:	1	Quantity:	EACH
Description:	12" grooves at top of curb ramp are not level (4.1% to 4.9%)		
As Built Desc:	4.5% at 12" grooves - New Construction		
Solution:	Demolish existing and construct new curb ramp		
Bar. Severity:	1 Necessary	Cost Estimate:	\$2,500.00
Implementation Priority:	1	Facility Function:	
Implementation Phase:		Implementation Date:	
Official Responsible:			
Notes:	Four - way intersection corners A,B,C,D corners. A A-B,B A-A,C A-A,C A-B compliant

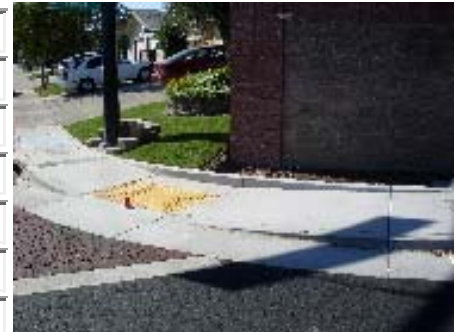
Field Date:	#####	Report Date:	10/14/2010	Barrier #:	654
Location:	Antelope Rd and Zenith Dr - Corner B (A-B)				
X Coordinate:	-121.31523				
Y Coordinate:	38.70752				
Barrier Area:	Curb Ramps				
Barrier Type:	12" Grooves - New Construction				
Code Ref:	CBC 1127B.5.6

As Built Meas:	1	Quantity:	EACH
Description:	12" grooves at top of curb ramp are not level (>5.0%)		
As Built Desc:	5.1% at 12" grooves - New Construction		
Solution:	Demolish existing and construct new curb ramp		
Bar. Severity:	1 Necessary	Cost Estimate:	\$2,500.00
Implementation Priority:	1	Facility Function:	
Implementation Phase:		Implementation Date:	
Official Responsible:			
Notes:	Four - way intersection corners A,B,C,D corners. A A-B,B A-A,C A-A,C A-B compliant

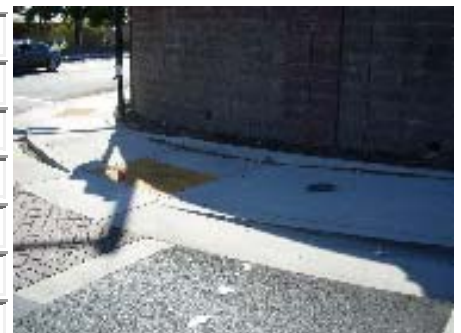
Field Date:	#####	Report Date:	10/14/2010	Barrier #:	655
Location:	Antelope Rd and Tupelo Dr - Corner D (A-A)				
X Coordinate:	-121.31557				
Y Coordinate:	38.70724				
Barrier Area:	Curb Ramps				
Barrier Type:	12" Grooves - New Construction				
Code Ref:	CBC 1127B.5.6

As Built Meas:	1	Quantity:	EACH
Description:	12" grooves at top of curb ramp are not level (>5.0%)		
As Built Desc:	6.4% at 12" grooves - New Construction		
Solution:	Demolish existing and construct new curb ramp		
Bar. Severity:	1 Necessary	Cost Estimate:	\$2,500.00
Implementation Priority:	1	Facility Function:	
Implementation Phase:		Implementation Date:	
Official Responsible:			
Notes:	Four - way intersection corners A,B,C,D corners. A A-B,B A-A,C A-A,C A-B compliant

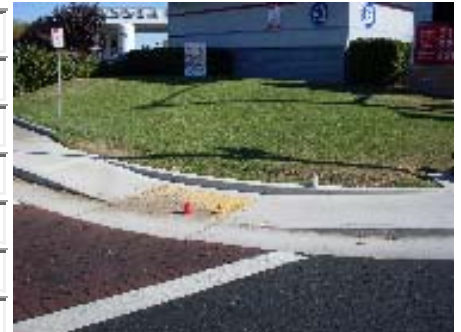
Field Date:	#####	Report Date:	10/14/2010	Barrier #:	656
Location:	Antelope Rd and Tupelo Dr - Corner D (A-B)				
X Coordinate:	-121.31557				
Y Coordinate:	38.70724				
Barrier Area:	Curb Ramps				
Barrier Type:	12" Grooves - New Construction				
Code Ref:	CBC 1127B.5.6

As Built Meas:	1	Quantity:	EACH
Description:	12" grooves at top of curb ramp are not level (>5.0%)		
As Built Desc:	6.4% at 12" grooves - New Construction		
Solution:	Demolish existing and construct new curb ramp		
Bar. Severity:	1 Necessary	Cost Estimate:	\$2,500.00
Implementation Priority:	1	Facility Function:	
Implementation Phase:		Implementation Date:	
Official Responsible:			
Notes:	Four - way intersection corners A,B,C,D corners. A A-B,B A-A,C A-A,C A-B compliant

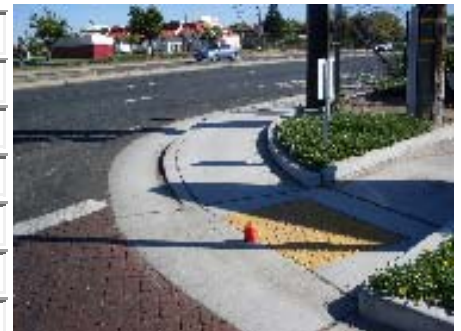
Field Date:	#####	Report Date:	10/14/2010	Barrier #:	657
Location:	Antelope Rd and Lichen Dr - Corner B				
X Coordinate:	-121.31335				
Y Coordinate:	38.70756				
Barrier Area:	Curb Ramps				
Barrier Type:	12" Grooves - New Construction				
Code Ref:	CBC 1127B.5.6

As Built Meas:	1	Quantity:	EACH
Description:	12" grooves at top of curb ramp are not level (>5.0%)		
As Built Desc:	6.3% at 12" grooves - New Construction		
Solution:	Demolish existing and construct new curb ramp		
Bar. Severity:	1 Necessary	Cost Estimate:	\$2,500.00
Implementation Priority:	1	Facility Function:	
Implementation Phase:		Implementation Date:	
Official Responsible:			
Notes:	Two - way intersection corners A,B. Corners A A-A,A A-B compliant

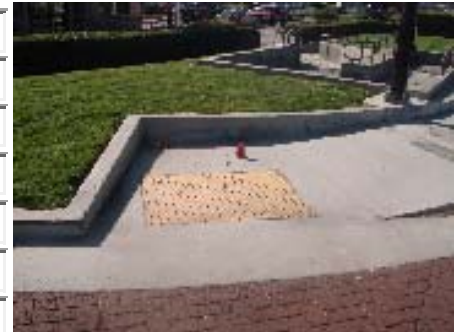
Field Date:	#####	Report Date:	10/14/2010	Barrier #:	658
Location:	Antelope Rd and Lichen Dr - Corner C				
X Coordinate:	-121.31316				
Y Coordinate:	38.70730				
Barrier Area:	Curb Ramps				
Barrier Type:	12" Grooves - New Construction				
Code Ref:	CBC 1127B.5.6

As Built Meas:	1	Quantity:	EACH
Description:	12" grooves at top of curb ramp are not level (>5.0%)		
As Built Desc:	7.9% at 12" grooves - New Construction		
Solution:	Demolish existing and construct new curb ramp		
Bar. Severity:	1 Necessary	Cost Estimate:	\$2,500.00
Implementation Priority:	1	Facility Function:	
Implementation Phase:		Implementation Date:	
Official Responsible:			
Notes:	Two - way intersection corners C,D. Corner D compliant

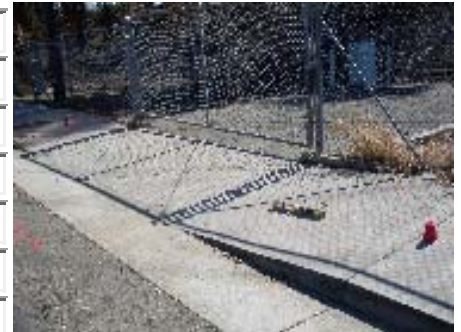
Field Date:	#####	Report Date:	10/14/2010	Barrier #:	660
Location:	Lichen Dr - East				
X Coordinate:	-121.31065				
Y Coordinate:	38.70858				
Barrier Area:	Sidewalks				
Barrier Type:	Driveway - New Construction				
Code Ref:	CBC 1133B.7.1.3 and ADA/ABA 403.3

As Built Meas:	29	Quantity:	LF
Description:	Driveway cross/running slope exceeds 2.0%		
As Built Desc:	4.5% cross slope, 10.7% running slope		
Solution:	Provide min. 48" wide level walkway through driveway		
Bar. Severity:	1 Necessary	Cost Estimate:	\$3,625.00
Implementation Priority:	2	Facility Function:	
Implementation Phase:		Implementation Date:	
Official Responsible:			
Notes:

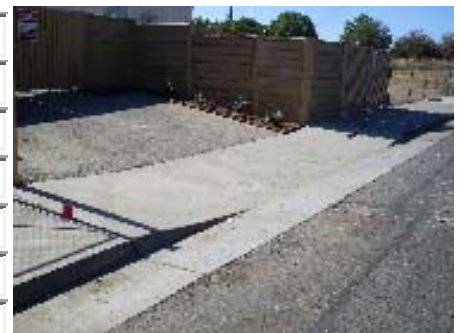
Field Date:	#####	Report Date:	10/14/2010	Barrier #:	661
Location:	Lichen Dr - East				
X Coordinate:	-121.31065				
Y Coordinate:	38.70858				
Barrier Area:	Sidewalks				
Barrier Type:	Driveway - New Construction				
Code Ref:	CBC 1133B.7.1.3 and ADA/ABA 403.3

As Built Meas:	26	Quantity:	LF
Description:	Driveway cross/running slope exceeds 2.0%		
As Built Desc:	4.5% cross slope, 10.6% running slope		
Solution:	Provide min. 48" wide level walkway through driveway		
Bar. Severity:	1 Necessary	Cost Estimate:	\$3,250.00
Implementation Priority:	2	Facility Function:	
Implementation Phase:		Implementation Date:	
Official Responsible:			
Notes:

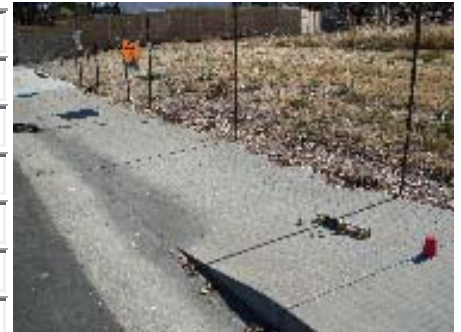
Field Date:	#####	Report Date:	10/14/2010	Barrier #:	662
Location:	Lichen Dr - East				
X Coordinate:	-121.31088				
Y Coordinate:	38.70860				
Barrier Area:	Sidewalks				
Barrier Type:	Driveway - Running Slope in New Construction				
Code Ref:	CBC 1133B.7.1.3 and ADA/ABA 403.3

As Built Meas:	5	Quantity:	LF		
Description:	Transition ramp into driveway not compliant (slope exceeds 8.3%)				
As Built Desc:	11.3% running slope				
Solution:	Demolish existing and construct new transition ramp				
Bar. Severity:	1 Necessary	Cost Estimate:	\$625.00	Status:	
Implementation Priority:	2	Facility Function:			
Implementation Phase:		Implementation Date:			
Official Responsible:

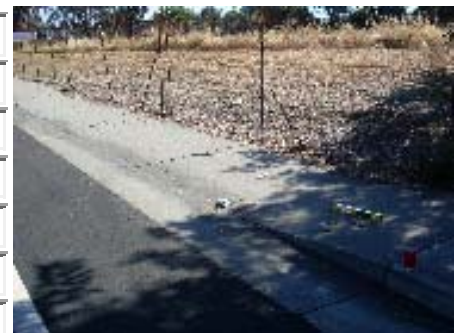
Field Date:	#####	Report Date:	10/14/2010	Barrier #:	663
Location:	Lichen Dr - East				
X Coordinate:	-121.31141				
Y Coordinate:	38.70852				
Barrier Area:	Sidewalks				
Barrier Type:	Driveway - Running Slope in New Construction				
Code Ref:	CBC 1133B.7.1.3 and ADA/ABA 403.3

As Built Meas:	5	Quantity:	LF		
Description:	Transition ramp into driveway not compliant (slope exceeds 8.3%)				
As Built Desc:	10.8% running slope				
Solution:	Demolish existing and construct new transition ramp				
Bar. Severity:	1 Necessary	Cost Estimate:	\$625.00	Status:	
Implementation Priority:	2	Facility Function:			
Implementation Phase:		Implementation Date:			
Official Responsible:

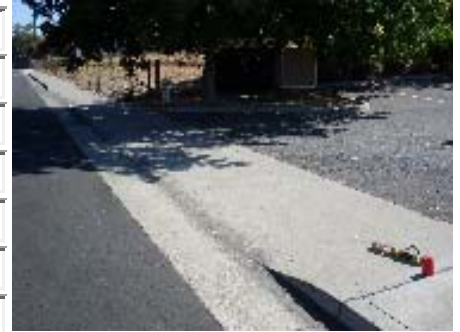
Field Date:	#####	Report Date:	10/14/2010	Barrier #:	664
Location:	Lichen Dr - East				
X Coordinate:	-121.31142				
Y Coordinate:	38.70851				
Barrier Area:	Sidewalks				
Barrier Type:	Driveway - New Construction				
Code Ref:	CBC 1133B.7.1.3 and ADA/ABA 403.3

As Built Meas:	36	Quantity:	LF
Description:	Driveway cross/running slope exceeds 2.0%		
As Built Desc:	6.1% cross slope, 13.1% running slope		
Solution:	Provide min. 48" wide level walkway through driveway		
Bar. Severity:	1 Necessary	Cost Estimate:	\$4,500.00
Implementation Priority:	2	Facility Function:	
Implementation Phase:		Implementation Date:	
Official Responsible:			
Notes:

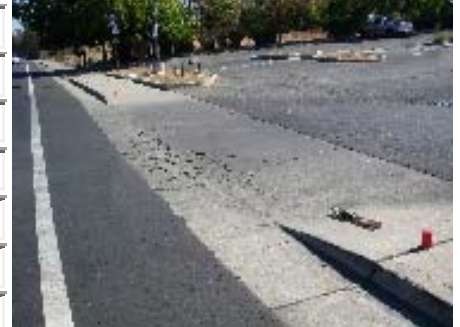
Field Date:	#####	Report Date:	10/14/2010	Barrier #:	665
Location:	Lichen Dr - East				
X Coordinate:	-121.31251				
Y Coordinate:	38.70838				
Barrier Area:	Sidewalks				
Barrier Type:	Driveway - New Construction				
Code Ref:	CBC 1133B.7.1.3 and ADA/ABA 403.3

As Built Meas:	42	Quantity:	LF
Description:	Driveway cross/running slope exceeds 2.0%		
As Built Desc:	9.4% cross slope, 9.5% running slope		
Solution:	Provide min. 48" wide level walkway through driveway		
Bar. Severity:	1 Necessary	Cost Estimate:	\$5,250.00
Implementation Priority:	2	Facility Function:	
Implementation Phase:		Implementation Date:	
Official Responsible:			
Notes:

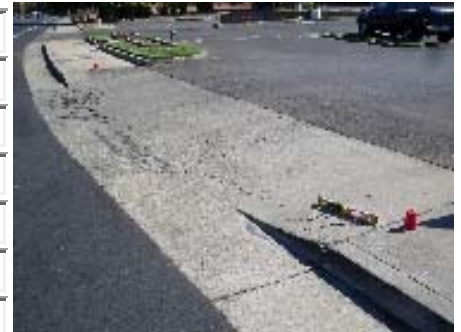
Field Date:	#####	Report Date:	10/14/2010	Barrier #:	666
Location:	Lichen Dr - East				
X Coordinate:	-121.31276				
Y Coordinate:	38.70831				
Barrier Area:	Sidewalks				
Barrier Type:	Driveway - New Construction				
Code Ref:	CBC 1133B.7.1.3 and ADA/ABA 403.3

As Built Meas:	31	Quantity:	LF
Description:	Driveway cross/running slope exceeds 2.0%		
As Built Desc:	9.5% cross slope, 10.8% running slope		
Solution:	Provide min. 48" wide level walkway through driveway		
Bar. Severity:	1 Necessary	Cost Estimate:	\$3,875.00
Implementation Priority:	2	Facility Function:	
Implementation Phase:		Implementation Date:	
Official Responsible:			
Notes:

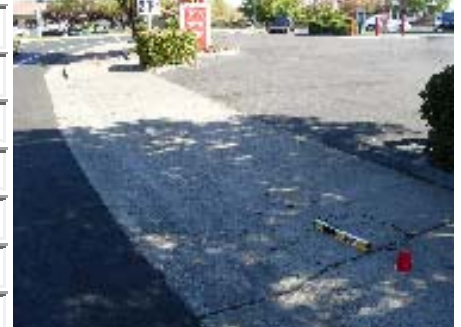
Field Date:	#####	Report Date:	10/14/2010	Barrier #:	667
Location:	Lichen Dr - East				
X Coordinate:	-121.31312				
Y Coordinate:	38.70811				
Barrier Area:	Sidewalks				
Barrier Type:	Driveway - Existing (5.0% or more)				
Code Ref:	CBC 1133B.7.1.3 and ADA/ABA 403.3

As Built Meas:	44	Quantity:	LF
Description:	Driveway cross slope exceeds 2.0% (5.0% or more)		
As Built Desc:	5.9% cross slope		
Solution:	Provide min. 48" wide level walkway through driveway		
Bar. Severity:	4 Low Severity	Cost Estimate:	\$5,500.00
Implementation Priority:	2	Facility Function:	
Implementation Phase:		Implementation Date:	
Official Responsible:			
Notes:

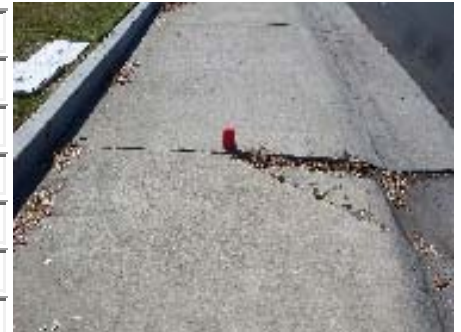
Field Date:	#####	Report Date:	10/14/2010	Barrier #:	668
Location:	Lichen Dr - East				
X Coordinate:	-121.31322				
Y Coordinate:	38.70799				
Barrier Area:	Sidewalks				
Barrier Type:	Surface Condition - Damaged				
Code Ref:	CBC 1133B.7.1 and ADA/ABA 302.1

As Built Meas:	3	Quantity:	LF		
Description:	Surface is not firm and stable (cracked, broken or loose soil, etc.)				
As Built Desc:	Cracked concrete				
Solution:	Repair surface to make firm and stable				
Bar. Severity:	1 Necessary	Cost Estimate:	\$375.00	Status:	
Implementation Priority:	2	Facility Function:			
Implementation Phase:		Implementation Date:			
Official Responsible:					
Notes:

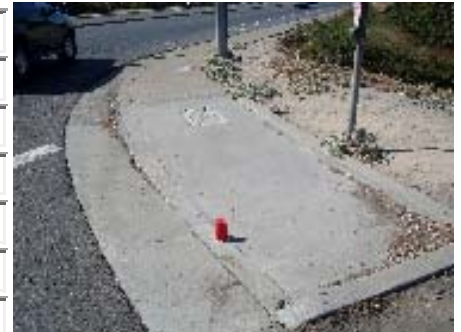
As Built Meas:	1	Quantity:	EACH
Description:	No truncated domes provided at curb ramp		
As Built Desc:	No detectable warnings at curb ramp		
Solution:	Provide compliant truncated domes		
Bar. Severity:	2 Recommended	Cost Estimate:	\$1,400.00
Implementation Priority:	1	Facility Function:	
Implementation Phase:		Implementation Date:	
Official Responsible:			
Notes:	Two - way intersection corners A,B

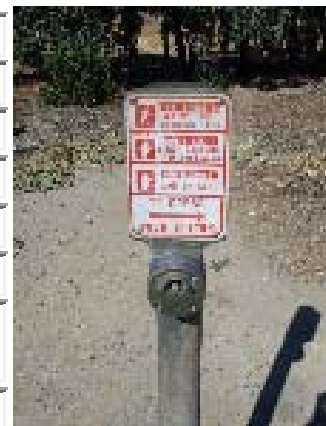
As Built Meas:	1	Quantity:	EACH
Description:	Pedestrian control push button mechanism not operable with a fist		
As Built Desc:	Not operable with a fist		
Solution:	Replace accessible pedestrian controls		
Bar. Severity:	1 Necessary	Cost Estimate:	\$4,700.00
Implementation Priority:	1	Facility Function:	
Implementation Phase:		Implementation Date:	
Official Responsible:			
Notes:	Two - way intersection corners A,B

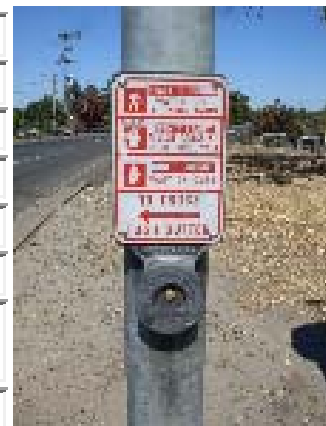
Field Date:	#####	Report Date:	10/14/2010	Barrier #:	670D
Location:	Antelope Rd and I-80 West exit ramp - Corner A (A-B)				
X Coordinate:	-121.31115				
Y Coordinate:	38.70759				
Barrier Area:	Signalized Intersections				
Barrier Type:	Ped Control Arrow				
Code Ref:	PROWAG R306.2

As Built Meas:	1	Quantity:	JOB
Description:	Pedestrian control arrow does not point in direction of travel		
As Built Desc:	Arrow does not point in direction of travel		
Solution:	Relocate accessible pedestrian controls		
Bar. Severity:	1 Necessary	Cost Estimate:	\$4,700.00
Implementation Priority:	1	Facility Function:	
Implementation Phase:		Implementation Date:	
Official Responsible:			
Notes:	Two - way intersection corners A,B

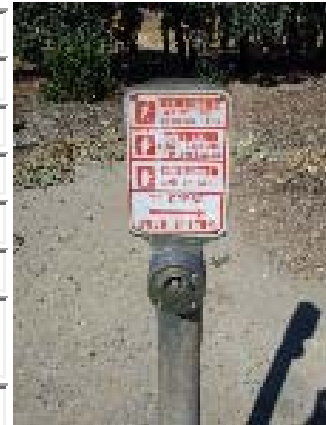
Field Date:	#####	Report Date:	10/14/2010	Barrier #:	670E
Location:	Antelope Rd and I-80 West exit ramp - Corner A (A-B)				
X Coordinate:	-121.31115				
Y Coordinate:	38.70759				
Barrier Area:	Signalized Intersections				
Barrier Type:	Ped Head - Countdown				
Code Ref:	N/A

As Built Meas:	1	Quantity:	EACH	
Description:	No countdown (LED) provided at intersection			
As Built Desc:	No countdown provided			
Solution:	Provide countdown (LED) provided at intersection			
Bar. Severity:	1 Necessary	Cost Estimate:	\$0.00	Status:
Implementation Priority:	1	Facility Function:		
Implementation Phase:		Implementation Date:		
Official Responsible:				
Notes:	Two - way intersection corners A,B

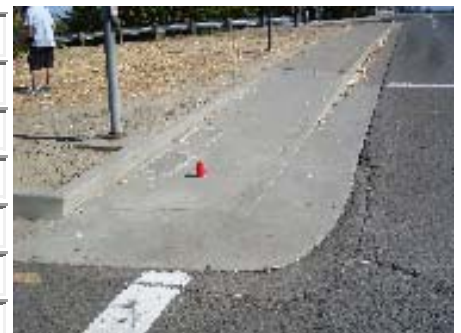
Field Date:	#####	Report Date:	10/14/2010	Barrier #:	671A
Location:	Antelope Rd and I-80 West exit ramp - Corner B				
X Coordinate:	-121.31082				
Y Coordinate:	38.70756				
Barrier Area:	Curb Ramps				
Barrier Type:	12" Grooves - Existing (>5.0%)				
Code Ref:	CBC 1127B.5.6

As Built Meas:	1	Quantity:	EACH	
Description:	12" grooves at top of curb ramp are not level (>5.0%)			
As Built Desc:	6.3% at 12" grooves			
Solution:	Demolish existing and construct new curb ramp			
Bar. Severity:	1 Necessary	Cost Estimate:	\$2,500.00	Status:
Implementation Priority:	1	Facility Function:		
Implementation Phase:		Implementation Date:		
Official Responsible:				
Notes:	Two - way intersection corners A,B

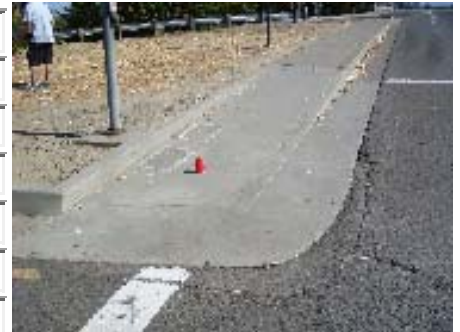
As Built Meas:	1	Quantity:	EACH
Description:	No truncated domes provided at curb ramp		
As Built Desc:	No detectable warnings at curb ramp		
Solution:	Provide compliant truncated domes		
Bar. Severity:	2 Recommended	Cost Estimate:	\$0.00
Implementation Priority:	1	Facility Function:	
Implementation Phase:		Implementation Date:	
Official Responsible:			
Notes:	Two - way intersection corners A,B

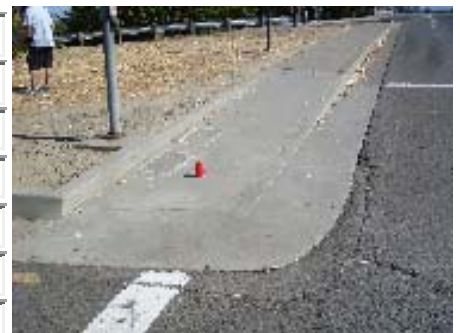
Field Date:	#####	Report Date:	10/14/2010	Barrier #:	671C
Location:	Antelope Rd and I-80 West exit ramp - Corner B				
X Coordinate:	-121.31082				
Y Coordinate:	38.70756				
Barrier Area:	Curb Ramps				
Barrier Type:	Lip - Gutter to Asphalt Transition				
Code Ref:	CBC 1127B.5.3 and ADA/ABA 303.3

As Built Meas:	1	Quantity:	EACH
Description:	Transition at transition into asphalt not flush and free of any lip		
As Built Desc:	1" lip at asphalt transition into roadway		
Solution:	Remove lip to create flush transition		
Bar. Severity:	1 Necessary	Cost Estimate:	\$0.00
Implementation Priority:	1	Facility Function:	
Implementation Phase:		Implementation Date:	
Official Responsible:			
Notes:	Two - way intersection corners A,B

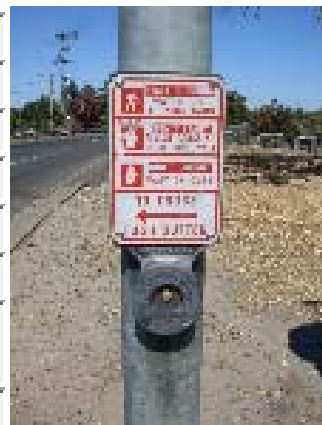
Barrier Type: Ped Controls - Push Button

Description: Pedestrian control push button mechanism not operable with a fist

Solution: Replace accessible pedestrian controls

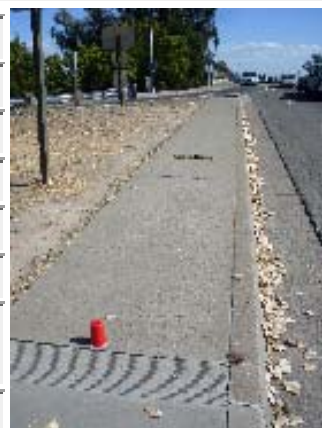
Barrier Type: Cross Slope - Existing (4.1% to 4.9%)

Description: Cross slope exceeds 2.0% (4.1% to 4.9%)

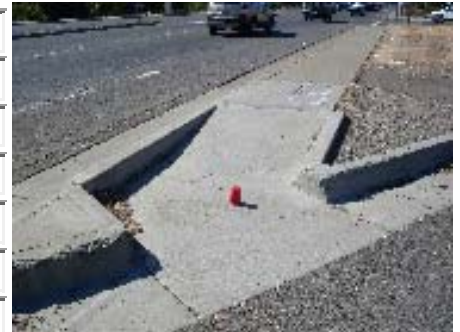
As Built Meas:	1	Quantity:	EACH
Description:	No truncated domes provided at curb ramp		
As Built Desc:	No detectable warnings at curb ramp		
Solution:	Provide compliant truncated domes		
Bar. Severity:	2 Recommended	Cost Estimate:	\$1,400.00
Implementation Priority:	4	Facility Function:	
Implementation Phase:		Implementation Date:	
Official Responsible:			
Notes:	Two - way intersection corners A,B

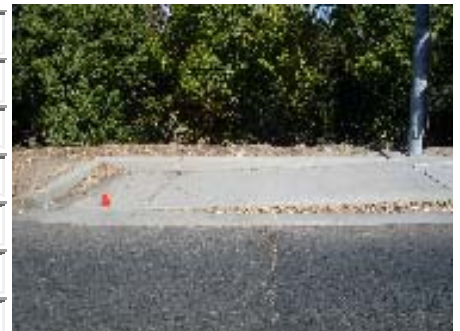
As Built Meas:	1	Quantity:	EACH
Description:	No truncated domes provided at curb ramp		
As Built Desc:	No detectable warnings at curb ramp		
Solution:	Provide compliant truncated domes		
Bar. Severity:	2 Recommended	Cost Estimate:	\$1,400.00
Implementation Priority:	4	Facility Function:	
Implementation Phase:		Implementation Date:	
Official Responsible:			
Notes:	Two - way intersection corners A,B

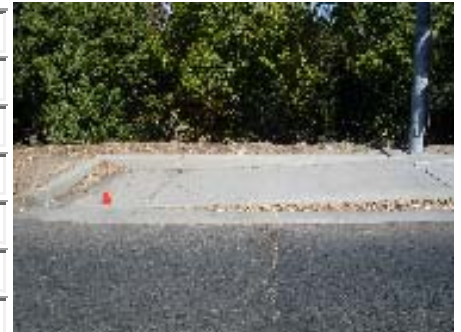
Barrier Type: Parallel Ramp Landing - Existing (>5.0% or more)

Code Ref: CBC 1127B.5.4 and ADA/ABA 406.4

Description: Curb ramp landing or pan not level (>5.0% or more)

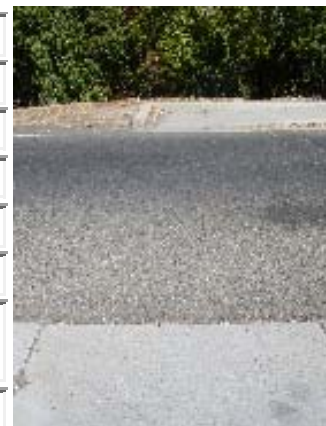
Barrier Type: Crosswalk Placement

Code Ref: CBC 1127B.5.1 and ADA/ABA 406.6

Description: No min. 48" route of travel between gutter and crosswalk stripe

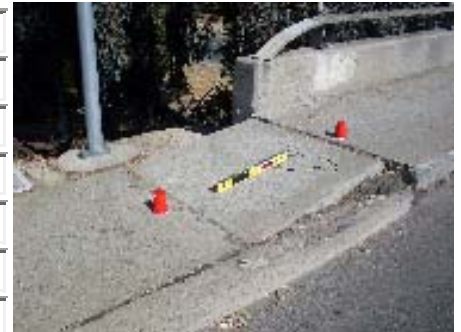
Barrier Type: Running Slope (Existing)

Code Ref: CBC 1133B.7.3 and ADA/ABA 403.3

Description: Running slope exceeds 5.0%

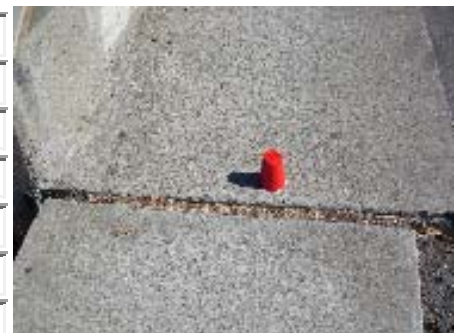
Barrier Type: Abrupt Change in Level - > 1/2"

Code Ref: CBC 1133B.7.1 and ADA/ABA 303.3

Description: Change in level greater than 1/2"

Solution: Grind or repair sidewalk to remove trip hazard

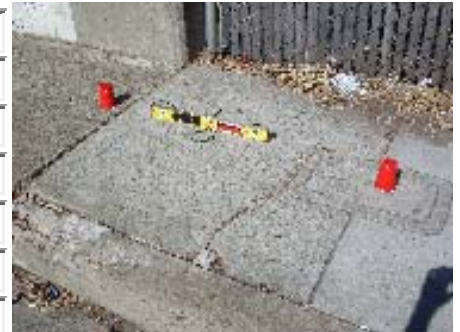
Field Date:	#####	Report Date:	10/14/2010	Barrier #:	677
Location:	Antelope Rd - North				
X Coordinate:	-121.31027				
Y Coordinate:	38.70756				
Barrier Area:	Sidewalks				
Barrier Type:	Running Slope (Existing)				
Code Ref:	CBC 1133B.7.3 and ADA/ABA 403.3

As Built Meas:	4	Quantity:	LF
Description:	Running slope exceeds 5.0%		
As Built Desc:	8.0% running slope		
Solution:	No remediation where sidewalk sloped as roadway		
Bar. Severity:	5 Technically Infeasible	Cost Estimate:	\$0.00
Implementation Priority:	1	Facility Function:	
Implementation Phase:		Implementation Date:	
Official Responsible:			
Notes:

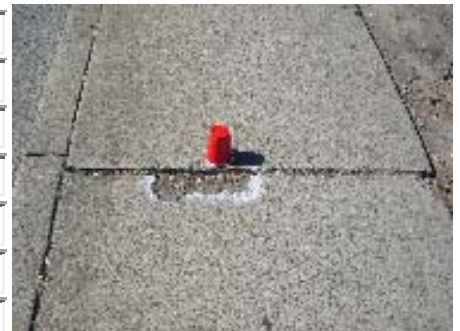
Field Date:	#####	Report Date:	10/14/2010	Barrier #:	678
Location:	Antelope Rd - North				
X Coordinate:	-121.30868				
Y Coordinate:	38.70756				
Barrier Area:	Sidewalks				
Barrier Type:	Surface Condition - Damaged				
Code Ref:	CBC 1133B.7.1 and ADA/ABA 302.1

As Built Meas:	3	Quantity:	LF
Description:	Surface is not firm and stable (cracked, broken or loose soil, etc.)		
As Built Desc:	Cracked concrete		
Solution:	Repair surface to make firm and stable		
Bar. Severity:	1 Necessary	Cost Estimate:	\$375.00
Implementation Priority:	1	Facility Function:	
Implementation Phase:		Implementation Date:	
Official Responsible:			
Notes:

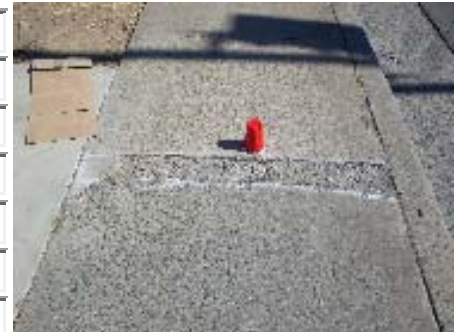
Field Date:	#####	Report Date:	10/14/2010	Barrier #:	679
Location:	Antelope Rd - North				
X Coordinate:	-121.30623				
Y Coordinate:	38.70758				
Barrier Area:	Sidewalks				
Barrier Type:	Surface Condition - Damaged				
Code Ref:	CBC 1133B.7.1 and ADA/ABA 302.1

As Built Meas:	4	Quantity:	LF
Description:	Surface is not firm and stable (cracked, broken or loose soil, etc.)		
As Built Desc:	Cracked concrete		
Solution:	Repair surface to make firm and stable		
Bar. Severity:	1 Necessary	Cost Estimate:	\$500.00
Implementation Priority:	1	Facility Function:	
Implementation Phase:		Implementation Date:	
Official Responsible:			
Notes:

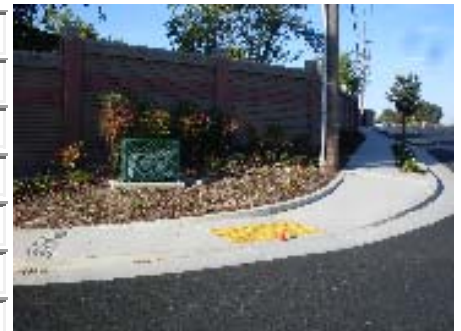
Field Date:	#####	Report Date:	10/15/2010	Barrier #:	680A
Location:	Antelope Rd and Mango Tree Wy - Corner D				
X Coordinate:	-121.32415				
Y Coordinate:	38.70712				
Barrier Area:	Curb Ramps				
Barrier Type:	12" Grooves - New Construction				
Code Ref:	CBC 1127B.5.6

As Built Meas:	1	Quantity:	EACH
Description:	12" grooves at top of curb ramp are not level (>5.0%)		
As Built Desc:	5.8% at 12" grooves - New Construction		
Solution:	Demolish existing and construct new curb ramp		
Bar. Severity:	1 Necessary	Cost Estimate:	\$2,500.00
Implementation Priority:	1	Facility Function:	
Implementation Phase:		Implementation Date:	
Official Responsible:			
Notes:	Two - way intersection corners C,D. Corner C compliant

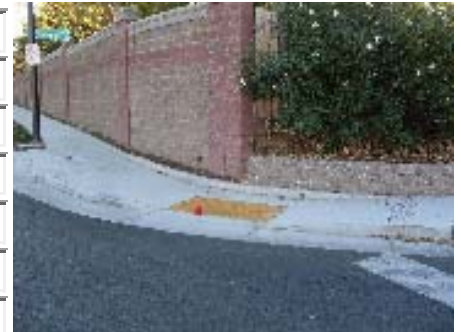
Barrier Type: Running Slope (New Construction)

Code Ref: CBC 1127B.5.3 and ADA/ABA 406.1

Description: Ramp run cross slope exceeds 2.0% (8.6% to 8.9%)

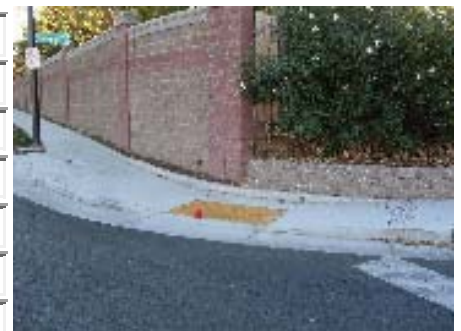
Barrier Type: 12" Grooves - New Construction

Code Ref: CBC 1127B.5.6

Description: 12" grooves at top of curb ramp are not level (>5.0%)

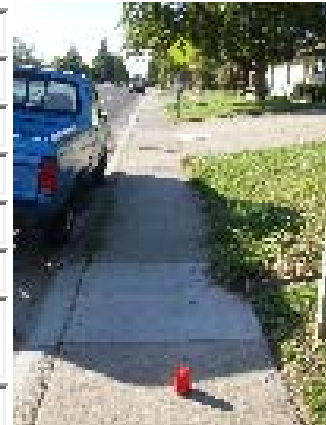
Barrier Type: Cross Slope - Existing (5.0% or more)

Code Ref: CBC 1133B.7.1.3 and ADA/ABA 403.3

Description: Cross slope exceeds 2.0% (5.0% or more)

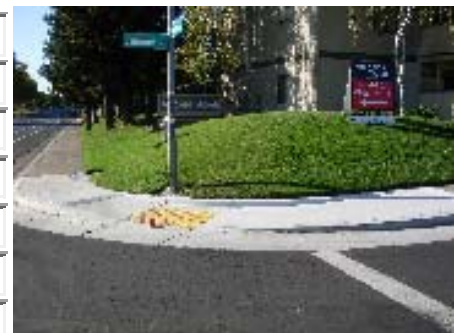
Barrier Type: 12" Grooves - New Construction

Code Ref: CBC 1127B.5.6

Description: 12" grooves at top of curb ramp are not level (4.1% to 4.9%)

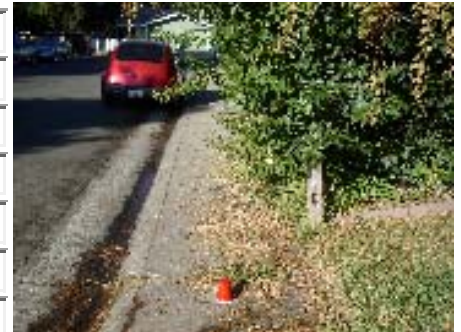
Field Date:	#####	Report Date:	10/15/2010	Barrier #:	684
Location:	Cunano Wy - North				
X Coordinate:	-121.31596				
Y Coordinate:	38.70561				
Barrier Area:	Sidewalks				
Barrier Type:	Clear Width - Existing ($\leq 31"$ or less)				
Code Ref:	CBC 1133B.7.1

As Built Meas:	1	Quantity:	LF
Description:	Pedestrian route is not min. 48" wide ($\leq 31"$ or less)		
As Built Desc:	24" clear width due to foliage		
Solution:	Trim foliage to provide min. 48" clear width		
Bar. Severity:	1 Necessary	Cost Estimate:	\$125.00
Implementation Priority:	4	Facility Function:	
Implementation Phase:		Implementation Date:	
Official Responsible:			
Notes:

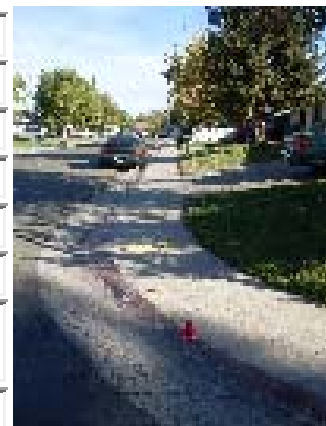
Field Date:	#####	Report Date:	10/15/2010	Barrier #:	685
Location:	Las Lilas Ct - East				
X Coordinate:	-121.31628				
Y Coordinate:	38.70561				
Barrier Area:	Sidewalks				
Barrier Type:	Elbow in Sidewalk - Cross Slope (5.0% or more)				
Code Ref:	CBC 1133B.7.1.3 and ADA/ABA 403.3

As Built Meas:	16	Quantity:	LF
Description:	Cross slope at elbow exceeds 2.0% (5.0% or more)		
As Built Desc:	8.1% cross slope		
Solution:	Demolish existing and construct new sidewalk without curb ramp		
Bar. Severity:	1 Necessary	Cost Estimate:	\$2,000.00
Implementation Priority:	4	Facility Function:	
Implementation Phase:		Implementation Date:	
Official Responsible:			
Notes:

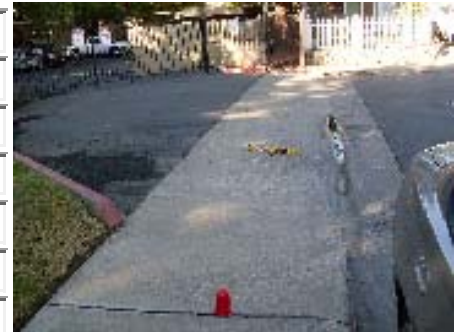
Field Date:	#####	Report Date:	10/15/2010	Barrier #:	686
Location:	Cunano Wy - South				
X Coordinate:	-121.31628				
Y Coordinate:	38.70551				
Barrier Area:	Sidewalks				
Barrier Type:	Driveway - New Construction				
Code Ref:	CBC 1133B.7.1.3 and ADA/ABA 403.3

As Built Meas:	44	Quantity:	LF
Description:	Driveway cross/running slope exceeds 2.0%		
As Built Desc:	10.1% cross slope, 8.8% running slope		
Solution:	Provide min. 48" wide level walkway through driveway		
Bar. Severity:	1 Necessary	Cost Estimate:	\$5,500.00
Implementation Priority:	4	Facility Function:	
Implementation Phase:		Implementation Date:	
Official Responsible:			
Notes:

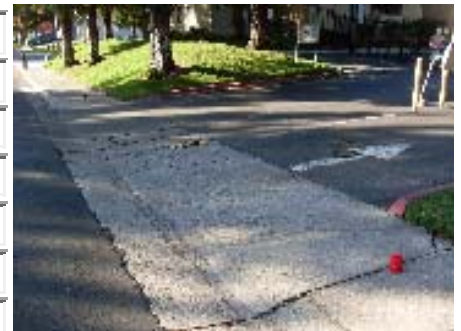
Field Date:	#####	Report Date:	10/15/2010	Barrier #:	687A
Location:	Tupelo Dr - East				
X Coordinate:	-121.31556				
Y Coordinate:	38.70495				
Barrier Area:	Sidewalks				
Barrier Type:	Driveway - Existing (4.1% to 4.9%)				
Code Ref:	CBC 1133B.7.1.3 and ADA/ABA 403.3

As Built Meas:	44	Quantity:	LF
Description:	Driveway cross slope exceeds 2.0% (4.1% to 4.9%)		
As Built Desc:	4.6% cross slope		
Solution:	Provide min. 48" wide level walkway through driveway		
Bar. Severity:	3 Hindrance	Cost Estimate:	\$5,500.00
Implementation Priority:	4	Facility Function:	
Implementation Phase:		Implementation Date:	
Official Responsible:			
Notes:

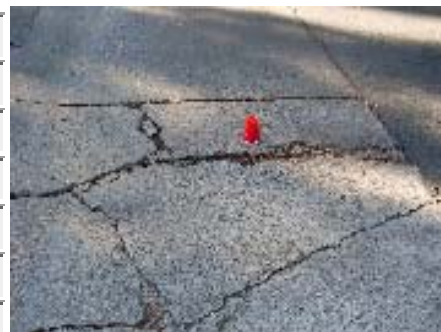
Barrier Type: Surface Condition - Damaged

Code Ref: CBC 1133B.7.1 and ADA/ABA 302.1

Description: Surface is not firm and stable (cracked, broken or loose soil, etc.)

As Built Desc: Cracked concrete

Solution: Repair surface to make firm and stable

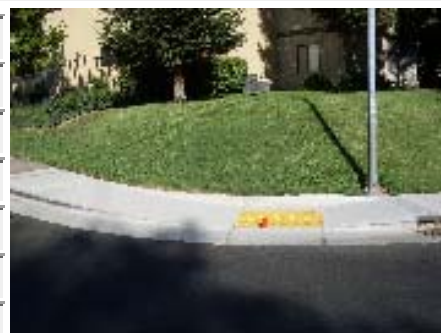
Barrier Type: 12" Grooves - New Construction

Code Ref: CBC 1127B.5.6

Description: 12" grooves at top of curb ramp are not level (>5.0%)

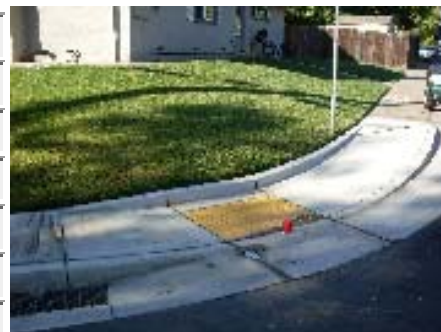
Barrier Type: 12" Grooves - New Construction

Code Ref: CBC 1127B.5.6

Description: 12" grooves at top of curb ramp are not level (4.1% to 4.9%)

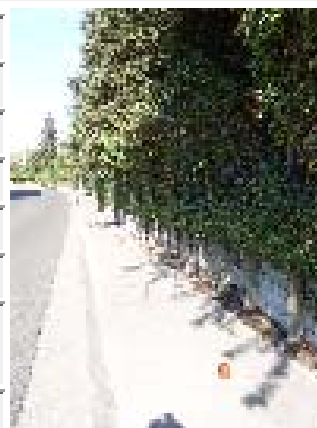
Barrier Type: Cross Slope - Existing (4.1% to 4.9%)

Code Ref: CBC 1133B.7.1.3 and ADA/ABA 403.3

Description: Cross slope exceeds 2.0% (4.1% to 4.9%)

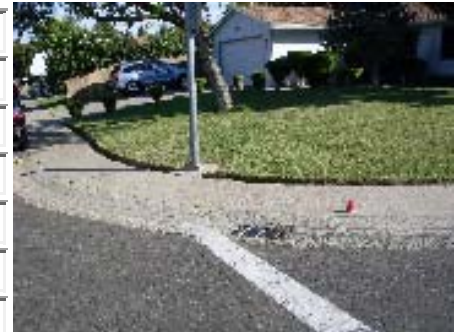
Field Date:	#####	Report Date:	10/15/2010	Barrier #:	691
Location:	Millwood Dr and Bierston St - Corner B				
X Coordinate:	-121.31847				
Y Coordinate:	38.70514				
Barrier Area:	Curb Ramps				
Barrier Type:	No Curb Ramp				
Code Ref:	CBC 1127B.5.1 and ADA/ABA 402.2

As Built Meas:	1	Quantity:	EACH
Description:	No curb cut at corner (intersection)		
As Built Desc:	No curb ramp at corner		
Solution:	Demolish existing and construct curb cut		
Bar. Severity:	1 Necessary	Cost Estimate:	\$2,500.00
Implementation Priority:	4	Facility Function:	
Implementation Phase:		Implementation Date:	
Official Responsible:			
Notes:	Two - way intersection corners B,C

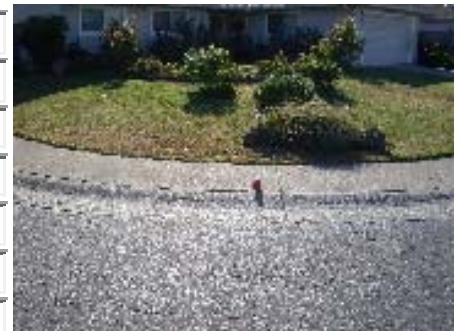
Field Date:	#####	Report Date:	10/15/2010	Barrier #:	692
Location:	Millwood Dr and Bierston St - Corner C				
X Coordinate:	-121.31845				
Y Coordinate:	38.70505				
Barrier Area:	Curb Ramps				
Barrier Type:	No Curb Ramp				
Code Ref:	CBC 1127B.5.1 and ADA/ABA 402.2

As Built Meas:	1	Quantity:	EACH
Description:	No curb cut at corner (intersection)		
As Built Desc:	No curb ramp at corner		
Solution:	Demolish existing and construct curb cut		
Bar. Severity:	1 Necessary	Cost Estimate:	\$2,500.00
Implementation Priority:	4	Facility Function:	
Implementation Phase:		Implementation Date:	
Official Responsible:			
Notes:	Two - way intersection corners B,C
