DRAFT ADA TRANSITION PLAN UPDATE
NEIGHBORHOOD AREA 1 NORTHWEST
SEPTEMBER 20, 2011

CITY OF CITRUS HEIGHTS

The Northwest Neighborhood Association

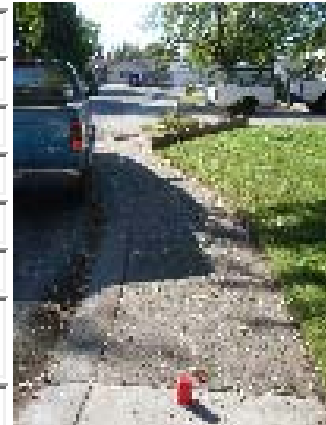
Barrier Type: Cross Slope - Existing (5.0% or more)

Code Ref: CBC 1133B.7.1.3 and ADA/ABA 403.3

Description: Cross slope exceeds 2.0% (5.0% or more)

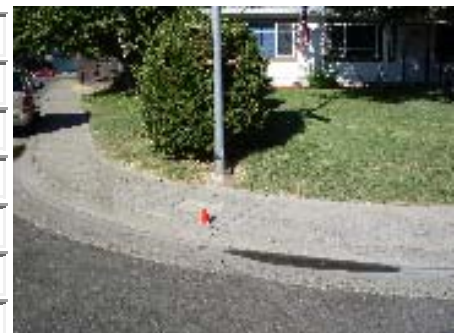
Barrier Type: No Curb Ramp

Code Ref: CBC 1127B.5.1 and ADA/ABA 402.2

Description: No curb cut at corner (intersection)

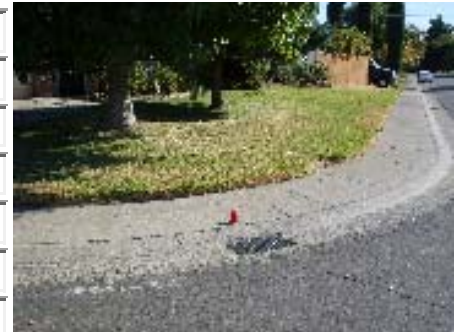
Field Date:	#####	Report Date:	10/15/2010	Barrier #:	697
Location:	Rumford Ave and Quincewood Cir - Corner B				
X Coordinate:	-121.32				
Y Coordinate:	38.70619				
Barrier Area:	Curb Ramps				
Barrier Type:	No Curb Ramp				
Code Ref:	CBC 1127B.5.1 and ADA/ABA 402.2

As Built Meas:	1	Quantity:	EACH
Description:	No curb cut at corner (intersection)		
As Built Desc:	No curb ramp at corner		
Solution:	Demolish existing and construct curb cut		
Bar. Severity:	1 Necessary	Cost Estimate:	\$2,500.00
Implementation Priority:	4	Facility Function:	
Implementation Phase:		Implementation Date:	
Official Responsible:			
Notes:	Two - way intersection corners A,B

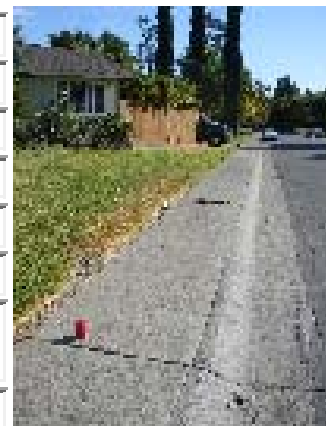
Field Date:	#####	Report Date:	10/15/2010	Barrier #:	698A
Location:	Rumford Ave - North				
X Coordinate:	-121.31988				
Y Coordinate:	38.70617				
Barrier Area:	Sidewalks				
Barrier Type:	Cross Slope - Existing (4.1% to 4.9%)				
Code Ref:	CBC 1133B.7.1.3 and ADA/ABA 403.3

As Built Meas:	371	Quantity:	LF
Description:	Cross slope exceeds 2.0% (4.1% to 4.9%)		
As Built Desc:	4.6% cross slope		
Solution:	Demolish existing and construct new route		
Bar. Severity:	2 Recommended	Cost Estimate:	\$46,375.00
Implementation Priority:	4	Facility Function:	
Implementation Phase:		Implementation Date:	
Official Responsible:			
Notes:

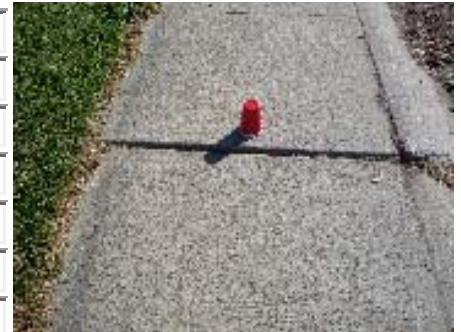
Barrier Type: Abrupt Change in Level - > 1/2"

Code Ref: CBC 1133B.7.1 and ADA/ABA 303.3

Description: Change in level greater than 1/2"

Solution: Grind or repair sidewalk to remove trip hazard

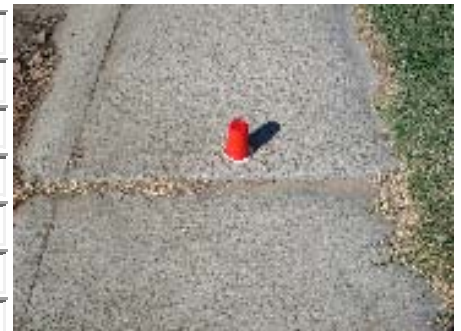
Barrier Type: Abrupt Change in Level - > 1/2"

Code Ref: CBC 1133B.7.1 and ADA/ABA 303.3

Description: Change in level greater than 1/2"

Solution: Grind or repair sidewalk to remove trip hazard

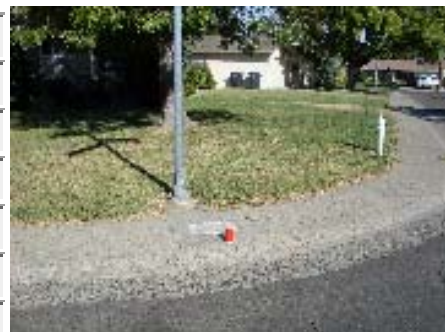
Barrier Type: No Curb Ramp

Code Ref: CBC 1127B.5.1 and ADA/ABA 402.2

Description: No curb cut at corner (intersection)

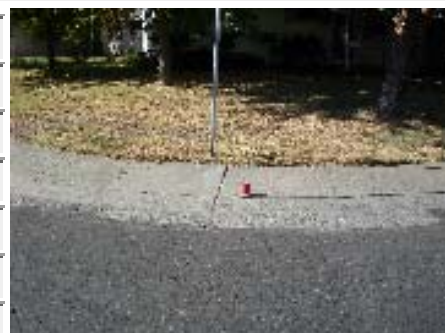
Barrier Type: No Curb Ramp

Code Ref: CBC 1127B.5.1 and ADA/ABA 402.2

Description: No curb cut at corner (intersection)

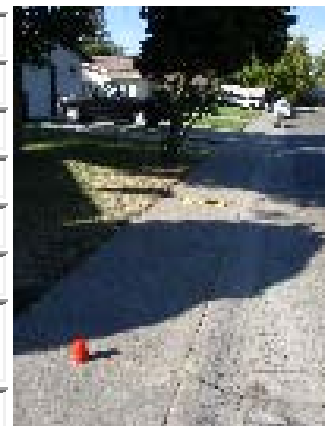
Field Date:	#####	Report Date:	10/15/2010	Barrier #:	703
Location:	Quincewood Cir - East				
X Coordinate:	-121.32001				
Y Coordinate:	38.7067				
Barrier Area:	Sidewalks				
Barrier Type:	Cross Slope - Existing (5.0% or more)				
Code Ref:	CBC 1133B.7.1.3 and ADA/ABA 403.3				
As Built Meas:	166	Quantity:	LF		
Description:	Cross slope exceeds 2.0% (5.0% or more)				
As Built Desc:	7.3% cross slope				
Solution:	Demolish existing and construct new route				
Bar. Severity:	1 Necessary	Cost Estimate:	\$20,750.00	Status:	
Implementation Priority:	4	Facility Function:			
Implementation Phase:		Implementation Date:			
Official Responsible:					
Notes:

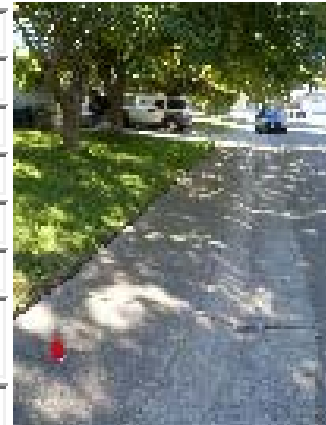
Field Date:	#####	Report Date:	10/15/2010	Barrier #:	704
Location:	Rumford Ave - North				
X Coordinate:	-121.32021				
Y Coordinate:	38.70622				
Barrier Area:	Sidewalks				
Barrier Type:	Cross Slope - Existing (5.0% or more)				
Code Ref:	CBC 1133B.7.1.3 and ADA/ABA 403.3				
As Built Meas:	182	Quantity:	LF		
Description:	Cross slope exceeds 2.0% (5.0% or more)				
As Built Desc:	5.2% cross slope				
Solution:	Demolish existing and construct new route				
Bar. Severity:	1 Necessary	Cost Estimate:	\$22,750.00	Status:	
Implementation Priority:	4	Facility Function:			
Implementation Phase:		Implementation Date:			
Official Responsible:					
Notes:

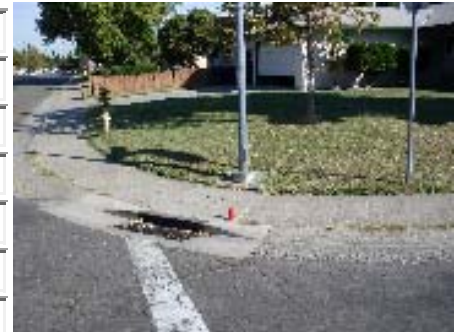
Field Date:	#####	Report Date:	10/15/2010	Barrier #:	705
Location:	Saybrook Dr and Rumford Ave - Corner B				
X Coordinate:	-121.32083				
Y Coordinate:	38.7062				
Barrier Area:	Curb Ramps				
Barrier Type:	No Curb Ramp				
Code Ref:	CBC 1127B.5.1 and ADA/ABA 402.2

As Built Meas:	1	Quantity:	EACH
Description:	No curb cut at corner (intersection)		
As Built Desc:	No curb ramp at corner		
Solution:	Demolish existing and construct curb cut		
Bar. Severity:	1 Necessary	Cost Estimate:	\$2,500.00
Implementation Priority:	4	Facility Function:	
Implementation Phase:		Implementation Date:	
Official Responsible:			
Notes:	Two - way intersection corners B,C

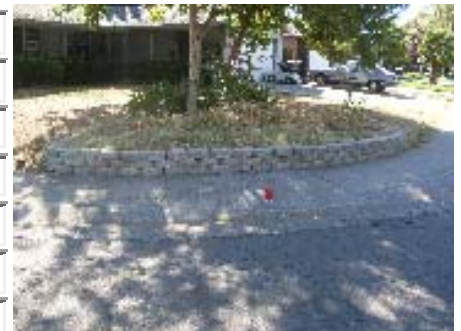
Field Date:	#####	Report Date:	10/15/2010	Barrier #:	706
Location:	Saybrook Dr and Rumford Ave - Corner C				
X Coordinate:	-121.32086				
Y Coordinate:	38.70607				
Barrier Area:	Curb Ramps				
Barrier Type:	No Curb Ramp				
Code Ref:	CBC 1127B.5.1 and ADA/ABA 402.2

As Built Meas:	1	Quantity:	EACH
Description:	No curb cut at corner (intersection)		
As Built Desc:	No curb ramp at corner		
Solution:	Demolish existing and construct curb cut		
Bar. Severity:	1 Necessary	Cost Estimate:	\$2,500.00
Implementation Priority:	4	Facility Function:	
Implementation Phase:		Implementation Date:	
Official Responsible:			
Notes:	Two - way intersection corners B,C

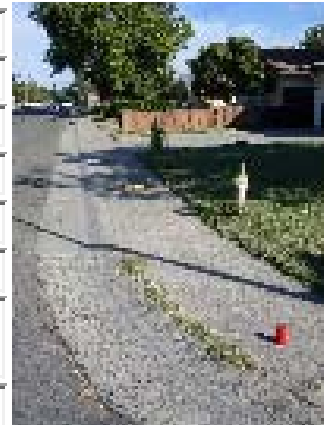
Field Date:	#####	Report Date:	10/15/2010	Barrier #:	707A
Location:	Saybrook Dr - East				
X Coordinate:	-121.32089				
Y Coordinate:	38.70623				
Barrier Area:	Sidewalks				
Barrier Type:	Cross Slope - Existing (5.0% or more)				
Code Ref:	CBC 1133B.7.1.3 and ADA/ABA 403.3

As Built Meas:	318	Quantity:	LF	
Description:	Cross slope exceeds 2.0% (5.0% or more)			
As Built Desc:	6.4% cross slope			
Solution:	Demolish existing and construct new route			
Bar. Severity:	1 Necessary	Cost Estimate:	\$39,750.00	Status:
Implementation Priority:	4	Facility Function:		
Implementation Phase:		Implementation Date:		
Official Responsible:

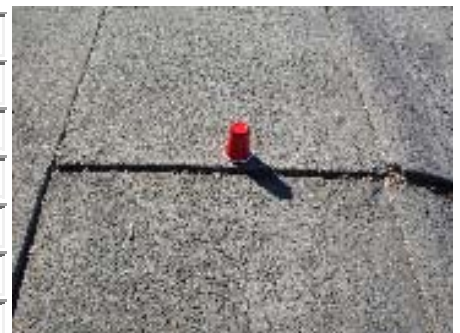
Field Date:	#####	Report Date:	10/15/2010	Barrier #:	707B
Location:	Saybrook Dr - East				
X Coordinate:	-121.32089				
Y Coordinate:	38.70663				
Barrier Area:	Sidewalks				
Barrier Type:	Abrupt Change in Level - > 1/2"				
Code Ref:	CBC 1133B.7.1 and ADA/ABA 303.3

As Built Meas:	4	Quantity:	LF	
Description:	Change in level greater than 1/2"			
As Built Desc:	1" lip in sidewalk surface			
Solution:	Grind or repair sidewalk to remove trip hazard			
Bar. Severity:	1 Necessary	Cost Estimate:	\$1,000.00	Status:
Implementation Priority:	4	Facility Function:		
Implementation Phase:		Implementation Date:		
Official Responsible:

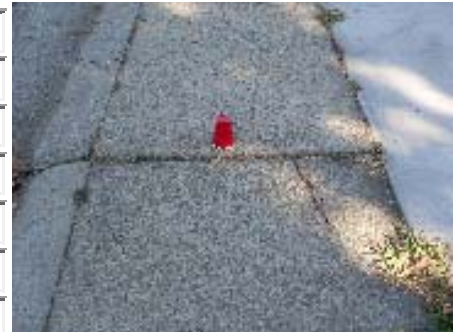
Field Date:	#####	Report Date:	10/15/2010	Barrier #:	707C
Location:	Saybrook Dr - East				
X Coordinate:	-121.32088				
Y Coordinate:	38.70684				
Barrier Area:	Sidewalks				
Barrier Type:	Abrupt Change in Level - > 1/2"				
Code Ref:	CBC 1133B.7.1 and ADA/ABA 303.3

As Built Meas:	4	Quantity:	LF
Description:	Change in level greater than 1/2"		
As Built Desc:	1" lip in sidewalk surface		
Solution:	Grind or repair sidewalk to remove trip hazard		
Bar. Severity:	1 Necessary	Cost Estimate:	\$1,000.00
Implementation Priority:	4	Facility Function:	
Implementation Phase:		Implementation Date:	
Official Responsible:			
Notes:

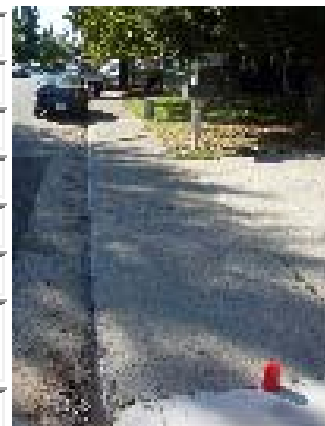
Field Date:	#####	Report Date:	10/15/2010	Barrier #:	708A
Location:	Pompei Ct - West				
X Coordinate:	-121.31772				
Y Coordinate:	38.70709				
Barrier Area:	Sidewalks				
Barrier Type:	Cross Slope - Existing (5.0% or more)				
Code Ref:	CBC 1133B.7.1.3 and ADA/ABA 403.3

As Built Meas:	364	Quantity:	LF
Description:	Cross slope exceeds 2.0% (5.0% or more)		
As Built Desc:	5.4% cross slope		
Solution:	Demolish existing and construct new route		
Bar. Severity:	1 Necessary	Cost Estimate:	\$45,500.00
Implementation Priority:	4	Facility Function:	
Implementation Phase:		Implementation Date:	
Official Responsible:			
Notes:

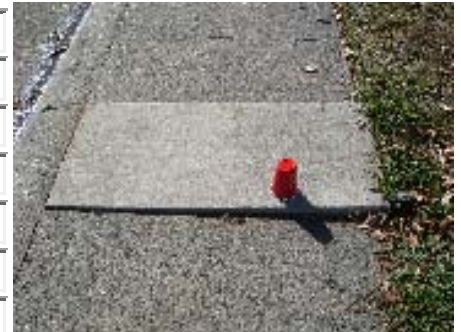
Field Date:	#####	Report Date:	10/15/2010	Barrier #:	708B
Location:	Pompei Ct - West				
X Coordinate:	-121.3177				
Y Coordinate:	38.70638				
Barrier Area:	Sidewalks				
Barrier Type:	Abrupt Change in Level - > 1/2"				
Code Ref:	CBC 1133B.7.1 and ADA/ABA 303.3

As Built Meas:	4	Quantity:	LF
Description:	Change in level greater than 1/2"		
As Built Desc:	1" lip in sidewalk surface		
Solution:	Grind or repair sidewalk to remove trip hazard		
Bar. Severity:	1 Necessary	Cost Estimate:	\$1,000.00
Implementation Priority:	4	Facility Function:	
Implementation Phase:		Implementation Date:	
Official Responsible:			
Notes:

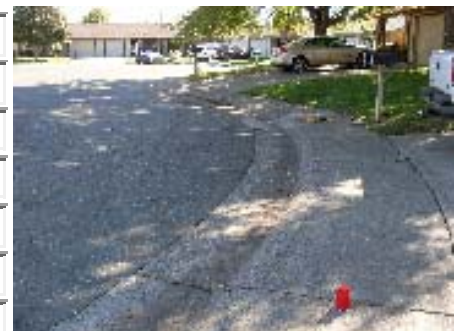
Field Date:	#####	Report Date:	10/15/2010	Barrier #:	709
Location:	Pompei Ct - South				
X Coordinate:	-121.31766				
Y Coordinate:	38.70616				
Barrier Area:	Sidewalks				
Barrier Type:	Cross Slope - Existing (5.0% or more)				
Code Ref:	CBC 1133B.7.1.3 and ADA/ABA 403.3

As Built Meas:	221	Quantity:	LF
Description:	Cross slope exceeds 2.0% (5.0% or more)		
As Built Desc:	7.8% cross slope		
Solution:	Demolish existing and construct new route		
Bar. Severity:	1 Necessary	Cost Estimate:	\$27,625.00
Implementation Priority:	4	Facility Function:	
Implementation Phase:		Implementation Date:	
Official Responsible:			
Notes:

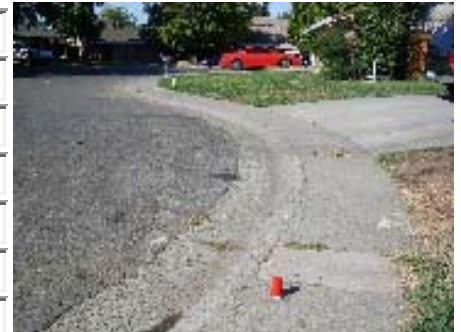
Field Date:	#####	Report Date:	10/15/2010	Barrier #:	710
Location:	Pompei Ct - North				
X Coordinate:	-121.31722				
Y Coordinate:	38.70626				
Barrier Area:	Sidewalks				
Barrier Type:	Cross Slope - Existing (5.0% or more)				
Code Ref:	CBC 1133B.7.1.3 and ADA/ABA 403.3

As Built Meas:	170	Quantity:	LF
Description:	Cross slope exceeds 2.0% (5.0% or more)		
As Built Desc:	8.6% cross slope		
Solution:	Demolish existing and construct new route		
Bar. Severity:	1 Necessary	Cost Estimate:	\$21,250.00
Implementation Priority:	4	Facility Function:	
Implementation Phase:		Implementation Date:	
Official Responsible:

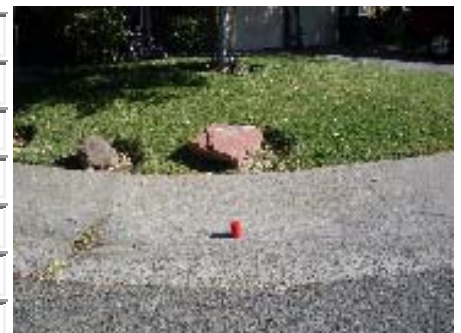
Field Date:	#####	Report Date:	10/15/2010	Barrier #:	712
Location:	Pompei Ct and Pompei Ct - Corner B				
X Coordinate:	-121.31758				
Y Coordinate:	38.70689				
Barrier Area:	Curb Ramps				
Barrier Type:	No Curb Ramp - Depressed Existing Curb				
Code Ref:	CBC 1127B.5.1 and ADA/ABA 402.2

As Built Meas:	1	Quantity:	EACH
Description:	No compliant curb cut at corner (intersection)		
As Built Desc:	13.3% running slope at depressed area		
Solution:	Demolish existing and construct curb cut		
Bar. Severity:	1 Necessary	Cost Estimate:	\$2,500.00
Implementation Priority:	4	Facility Function:	
Implementation Phase:		Implementation Date:	
Official Responsible:

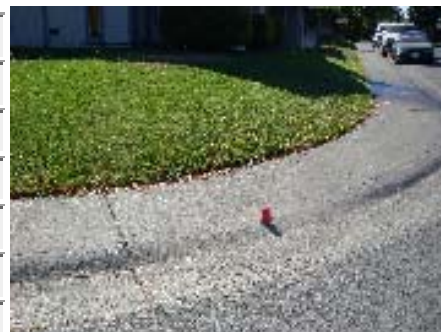
Barrier Type: No Curb Ramp - Depressed Exsiting Curb

Description: No compliant curb cut at corner (intersection)

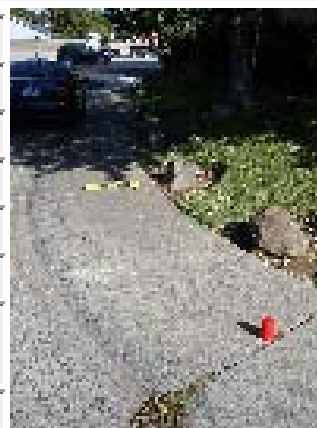
Barrier Type: Cross Slope - Existing (4.1% to 4.9%)

Description: Cross slope exceeds 2.0% (4.1% to 4.9%)

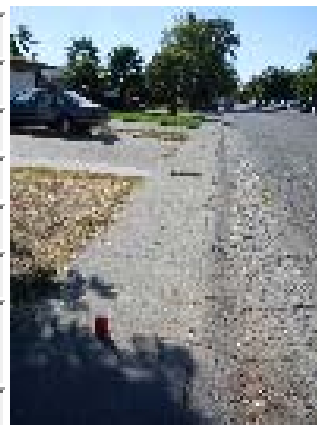
Barrier Type: Cross Slope - Existing (4.1% to 4.9%)

Description: Cross slope exceeds 2.0% (4.1% to 4.9%)

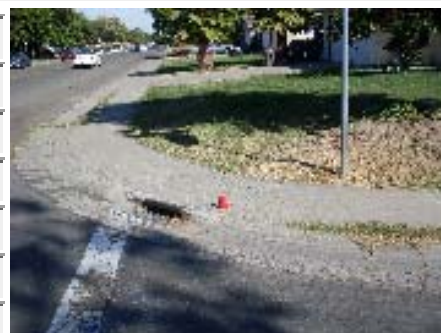
Barrier Type: No Curb Ramp

Description: No curb cut at corner (intersection)

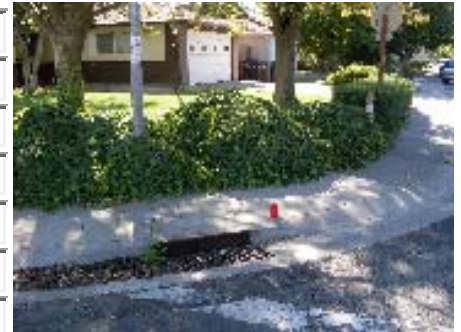
Field Date:	#####	Report Date:	10/15/2010	Barrier #:	716
Location:	Saybrook Dr and Pinecreek Wy - Corner C				
X Coordinate:	-121.32087				
Y Coordinate:	38.70538				
Barrier Area:	Curb Ramps				
Barrier Type:	No Curb Ramp				
Code Ref:	CBC 1127B.5.1 and ADA/ABA 402.2

As Built Meas:	1	Quantity:	EACH
Description:	No curb cut at corner (intersection)		
As Built Desc:	No curb ramp at corner		
Solution:	Demolish existing and construct curb cut		
Bar. Severity:	1 Necessary	Cost Estimate:	\$2,500.00
Implementation Priority:	4	Facility Function:	
Implementation Phase:		Implementation Date:	
Official Responsible:			
Notes:	Two - way intersection corners B,C

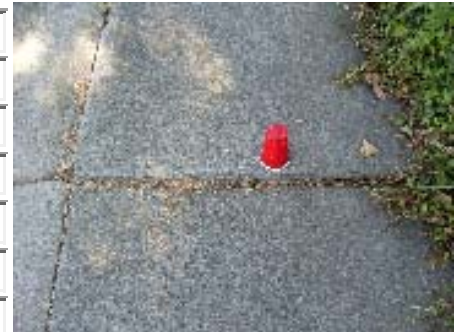
Field Date:	#####	Report Date:	10/15/2010	Barrier #:	718
Location:	Saybrook Dr - East				
X Coordinate:	-121.32087				
Y Coordinate:	38.70536				
Barrier Area:	Sidewalks				
Barrier Type:	Abrupt Change in Level - > 1/2"				
Code Ref:	CBC 1133B.7.1 and ADA/ABA 303.3

As Built Meas:	4	Quantity:	LF
Description:	Change in level greater than 1/2"		
As Built Desc:	1" lip in sidewalk surface		
Solution:	Grind or repair sidewalk to remove trip hazard		
Bar. Severity:	1 Necessary	Cost Estimate:	\$1,000.00
Implementation Priority:	4	Facility Function:	
Implementation Phase:		Implementation Date:	
Official Responsible:			
Notes:

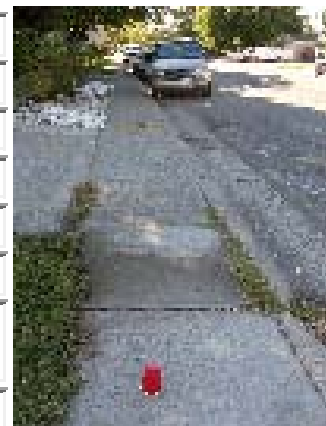
Field Date:	#####	Report Date:	10/15/2010	Barrier #:	719
Location:	Saybrook Dr - East				
X Coordinate:	-121.32085				
Y Coordinate:	38.70516				
Barrier Area:	Sidewalks				
Barrier Type:	Cross Slope - Existing (5.0% or more)				
Code Ref:	CBC 1133B.7.1.3 and ADA/ABA 403.3

As Built Meas:	459	Quantity:	LF
Description:	Cross slope exceeds 2.0% (5.0% or more)		
As Built Desc:	6.1% cross slope		
Solution:	Demolish existing and construct new route		
Bar. Severity:	1 Necessary	Cost Estimate:	\$57,375.00
Implementation Priority:	4	Facility Function:	
Implementation Phase:		Implementation Date:	
Official Responsible:			
Notes:

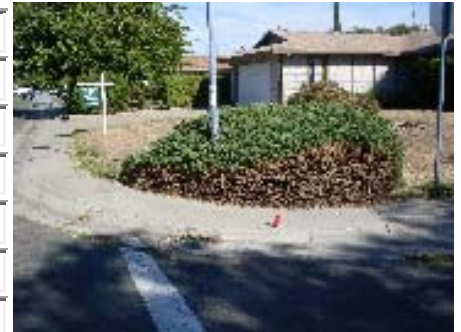
Field Date:	#####	Report Date:	10/15/2010	Barrier #:	720
Location:	Saybrook Dr and Pinecreek Wy - Corner B				
X Coordinate:	-121.32067				
Y Coordinate:	38.7039				
Barrier Area:	Curb Ramps				
Barrier Type:	No Curb Ramp				
Code Ref:	CBC 1127B.5.1 and ADA/ABA 402.2

As Built Meas:	1	Quantity:	EACH
Description:	No curb cut at corner (intersection)		
As Built Desc:	No curb ramp at corner		
Solution:	Demolish existing and construct curb cut		
Bar. Severity:	1 Necessary	Cost Estimate:	\$2,500.00
Implementation Priority:	4	Facility Function:	
Implementation Phase:		Implementation Date:	
Official Responsible:			
Notes:	Two - way intersection corners B,C

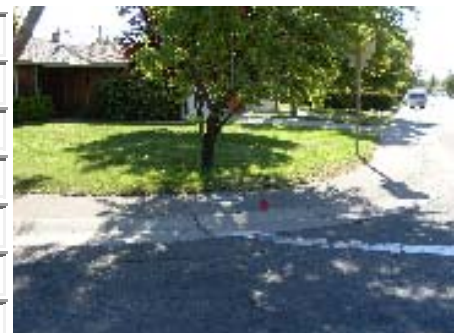
Field Date:	#####	Report Date:	10/15/2010	Barrier #:	721
Location:	Saybrook Dr and Pinecreek Wy - Corner C				
X Coordinate:	-121.32067				
Y Coordinate:	38.7038				
Barrier Area:	Curb Ramps				
Barrier Type:	No Curb Ramp				
Code Ref:	CBC 1127B.5.1 and ADA/ABA 402.2

As Built Meas:	1	Quantity:	EACH
Description:	No curb cut at corner (intersection)		
As Built Desc:	No curb ramp at corner		
Solution:	Demolish existing and construct curb cut		
Bar. Severity:	1 Necessary	Cost Estimate:	\$2,500.00
Implementation Priority:	4	Facility Function:	
Implementation Phase:		Implementation Date:	
Official Responsible:			
Notes:	Two - way intersection corners B,C

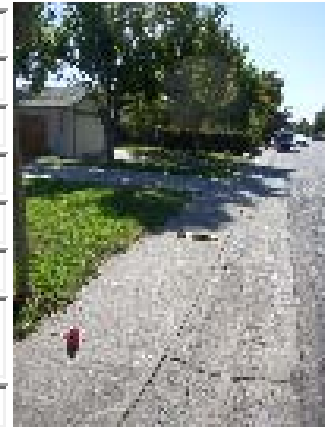
Barrier Type: Cross Slope - Existing (5.0% or more)

Description: Cross slope exceeds 2.0% (5.0% or more)

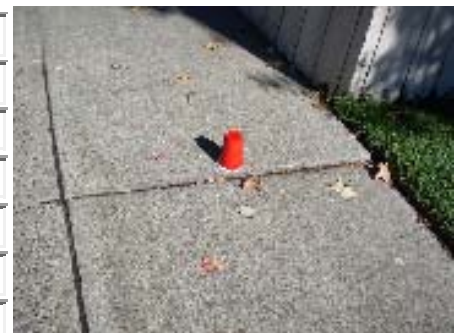
Barrier Type: Abrupt Change in Level - > 1/2"

Description: Change in level greater than 1/2"

Solution: Grind or repair sidewalk to remove trip hazard

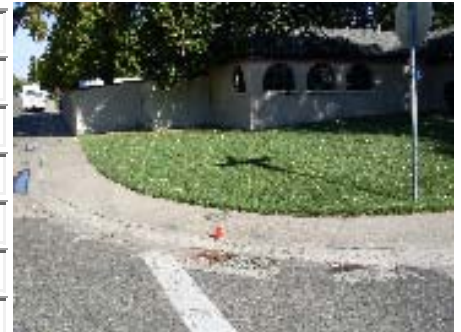
Field Date:	#####	Report Date:	10/15/2010	Barrier #:	723
Location:	Glenhurst Wy and Saybrook Dr - Corner B				
X Coordinate:	-121.32043				
Y Coordinate:	38.7026				
Barrier Area:	Curb Ramps				
Barrier Type:	No Curb Ramp				
Code Ref:	CBC 1127B.5.1 and ADA/ABA 402.2

As Built Meas:	1	Quantity:	EACH		
Description:	No curb cut at corner (intersection)				
As Built Desc:	No curb ramp at corner				
Solution:	Demolish existing and construct curb cut				
Bar. Severity:	1 Necessary	Cost Estimate:	\$2,500.00	Status:	
Implementation Priority:	4	Facility Function:			
Implementation Phase:		Implementation Date:			
Official Responsible:					
Notes:	Two - way intersection corners B,C

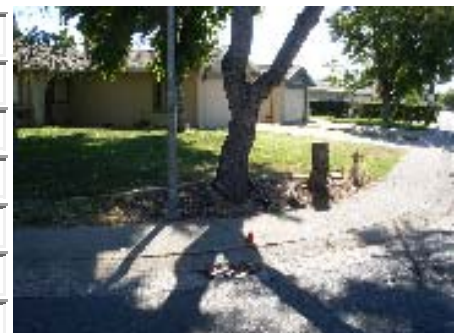
Field Date:	#####	Report Date:	10/15/2010	Barrier #:	724
Location:	Glenhurst Wy and Saybrook Dr - Corner C				
X Coordinate:	-121.32035				
Y Coordinate:	38.70251				
Barrier Area:	Curb Ramps				
Barrier Type:	No Curb Ramp				
Code Ref:	CBC 1127B.5.1 and ADA/ABA 402.2

As Built Meas:	1	Quantity:	EACH		
Description:	No curb cut at corner (intersection)				
As Built Desc:	No curb ramp at corner				
Solution:	Demolish existing and construct curb cut				
Bar. Severity:	1 Necessary	Cost Estimate:	\$2,500.00	Status:	
Implementation Priority:	4	Facility Function:			
Implementation Phase:		Implementation Date:			
Official Responsible:					
Notes:	Two - way intersection corners B,C

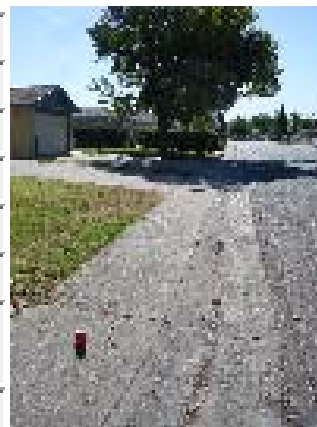
Barrier Type: Cross Slope - Existing (5.0% or more)

Description: Cross slope exceeds 2.0% (5.0% or more)

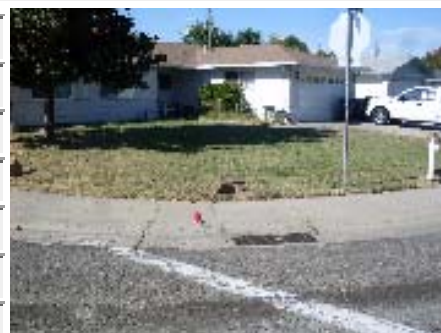
Barrier Type: No Curb Ramp

Description: No curb cut at corner (intersection)

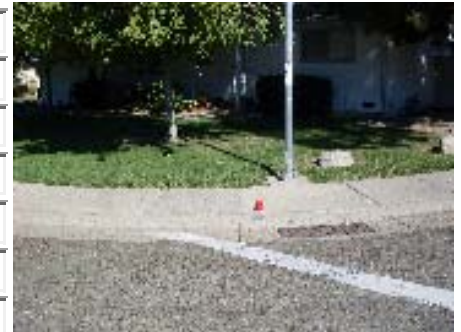
Barrier Type: No Curb Ramp

Description: No curb cut at corner (intersection)

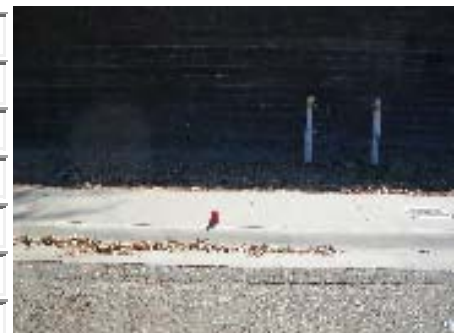
Barrier Type: No Curb Ramp

Code Ref: CBC 1127B.5.1 and ADA/ABA 402.2

As Built Meas: 1 Quantity: EACH

Description: No curb cut at corner (intersection)

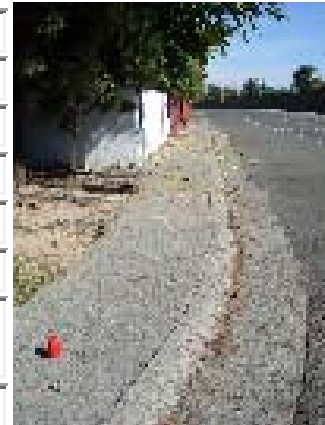
Barrier Type: Cross Slope - Existing (5.0% or more)

Code Ref: CBC 1133B.7.1.3 and ADA/ABA 403.3

As Built Meas: 175 Quantity: LF

Description: Cross slope exceeds 2.0% (5.0% or more)

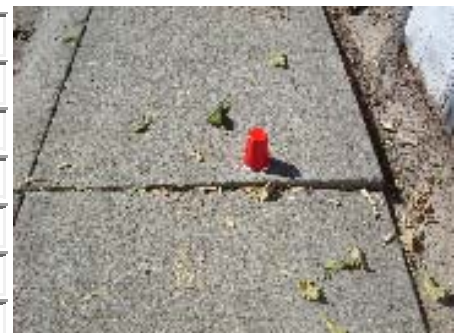
Barrier Type: Abrupt Change in Level - > 1/2"

Code Ref: CBC 1133B.7.1 and ADA/ABA 303.3

As Built Meas: 4 Quantity: LF

Description: Change in level greater than 1/2"

Solution: Grind or repair sidewalk to remove trip hazard

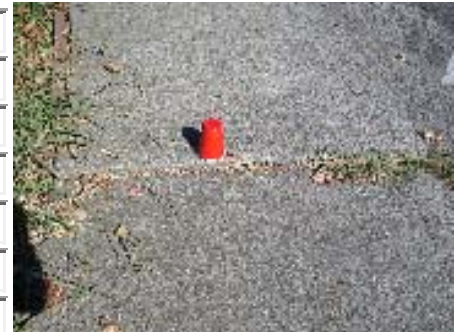
Barrier Type: Abrupt Change in Level - > 1/2"

Code Ref: CBC 1133B.7.1 and ADA/ABA 303.3

As Built Meas: 4 Quantity: LF

Description: Change in level greater than 1/2"

Solution: Grind or repair sidewalk to remove trip hazard

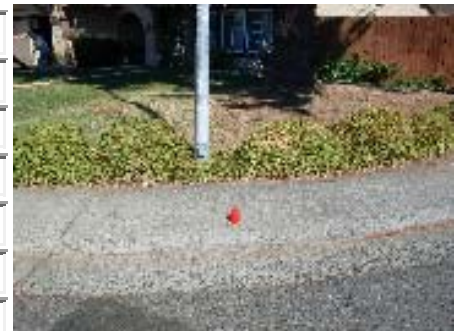
Barrier Type: No Curb Ramp - Depressed Exsiting Curb

Code Ref: CBC 1127B.5.1 and ADA/ABA 402.2

As Built Meas: 1 Quantity: EACH

Description: No compliant curb cut at corner (intersection)

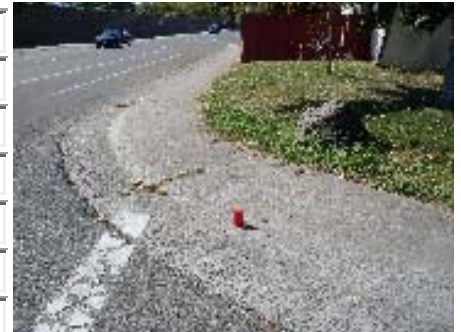
Field Date:	#####	Report Date:	10/15/2010	Barrier #:	730
Location:	Tupelo Dr and Mar Vista Wy - Corner D				
X Coordinate:	-121.31843				
Y Coordinate:	38.70042				
Barrier Area:	Curb Ramps				
Barrier Type:	No Curb Ramp - Depressed Exsiting Curb				
Code Ref:	CBC 1127B.5.1 and ADA/ABA 402.2

As Built Meas:	1	Quantity:	EACH		
Description:	No compliant curb cut at corner (intersection)				
As Built Desc:	11.4% running slope at depressed area				
Solution:	Demolish existing and construct curb cut				
Bar. Severity:	1 Necessary	Cost Estimate:	\$2,500.00	Status:	
Implementation Priority:	4	Facility Function:			
Implementation Phase:		Implementation Date:			
Official Responsible:					
Notes:	Two - way intersection corners A,D

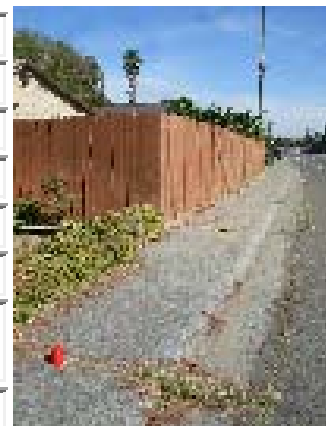
Field Date:	#####	Report Date:	10/15/2010	Barrier #:	732A
Location:	Tupelo Dr - North				
X Coordinate:	-121.31827				
Y Coordinate:	38.70055				
Barrier Area:	Sidewalks				
Barrier Type:	Cross Slope - Existing (5.0% or more)				
Code Ref:	CBC 1133B.7.1.3 and ADA/ABA 403.3

As Built Meas:	528	Quantity:	LF		
Description:	Cross slope exceeds 2.0% (5.0% or more)				
As Built Desc:	5.4% cross slope				
Solution:	Demolish existing and construct new route				
Bar. Severity:	1 Necessary	Cost Estimate:	\$66,000.00	Status:	
Implementation Priority:	4	Facility Function:			
Implementation Phase:		Implementation Date:			
Official Responsible:					
Notes:

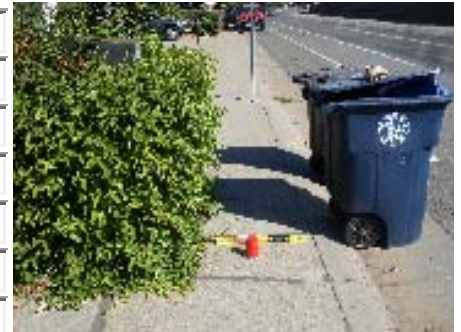
Field Date:	#####	Report Date:	10/15/2010	Barrier #:	732B
Location:	Tupelo Dr - North				
X Coordinate:	-121.31779				
Y Coordinate:	38.70098				
Barrier Area:	Sidewalks				
Barrier Type:	Clear Width - Existing ($\leq 31"$ or less)				
Code Ref:	CBC 1133B.7.1

As Built Meas:	1	Quantity:	LF		
Description:	Pedestrian route is not min. 48" wide ($\leq 31"$ or less)				
As Built Desc:	24" clear width due to foliage				
Solution:	Trim foliage to provide min. 48" clear width				
Bar. Severity:	1 Necessary	Cost Estimate:	\$125.00	Status:	
Implementation Priority:	4	Facility Function:			
Implementation Phase:		Implementation Date:			
Official Responsible:

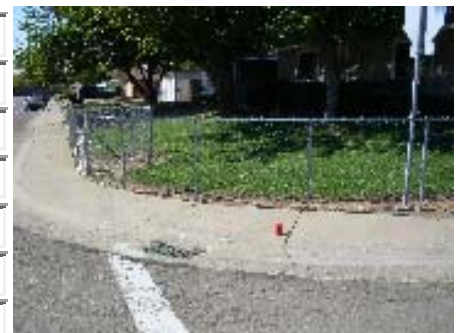
Field Date:	#####	Report Date:	10/15/2010	Barrier #:	733
Location:	Tupelo Dr and Wild Oak Dr - Corner A				
X Coordinate:	-121.3172				
Y Coordinate:	38.70173				
Barrier Area:	Curb Ramps				
Barrier Type:	No Curb Ramp				
Code Ref:	CBC 1127B.5.1 and ADA/ABA 402.2

As Built Meas:	1	Quantity:	EACH		
Description:	No curb cut at corner (intersection)				
As Built Desc:	No curb ramp at corner				
Solution:	Demolish existing and construct curb cut				
Bar. Severity:	1 Necessary	Cost Estimate:	\$2,500.00	Status:	
Implementation Priority:	4	Facility Function:			
Implementation Phase:		Implementation Date:			
Official Responsible:

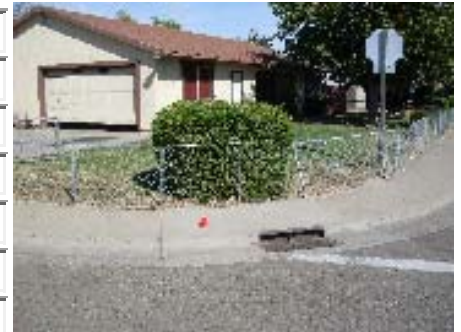
Field Date:	#####	Report Date:	10/15/2010	Barrier #:	734
Location:	Tupelo Dr and Wild Oak Dr - Corner B				
X Coordinate:	-121.31711				
Y Coordinate:	38.70185				
Barrier Area:	Curb Ramps				
Barrier Type:	No Curb Ramp				
Code Ref:	CBC 1127B.5.1 and ADA/ABA 402.2

As Built Meas:	1	Quantity:	EACH
Description:	No curb cut at corner (intersection)		
As Built Desc:	No curb ramp at corner		
Solution:	Demolish existing and construct curb cut		
Bar. Severity:	1 Necessary	Cost Estimate:	\$2,500.00
Implementation Priority:	4	Facility Function:	
Implementation Phase:		Implementation Date:	
Official Responsible:			
Notes:	Two - way intersection corners A,B

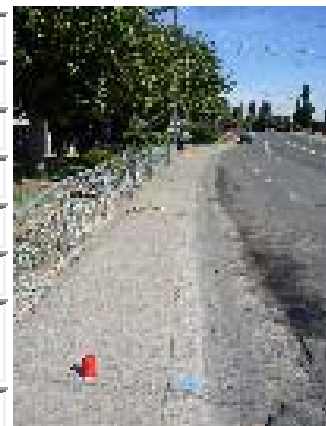
Field Date:	#####	Report Date:	10/15/2010	Barrier #:	735A
Location:	Tupelo Dr - North				
X Coordinate:	-121.31703				
Y Coordinate:	38.70191				
Barrier Area:	Sidewalks				
Barrier Type:	Cross Slope - Existing (5.0% or more)				
Code Ref:	CBC 1133B.7.1.3 and ADA/ABA 403.3

As Built Meas:	282	Quantity:	LF
Description:	Cross slope exceeds 2.0% (5.0% or more)		
As Built Desc:	5.2% cross slope		
Solution:	Demolish existing and construct new route		
Bar. Severity:	1 Necessary	Cost Estimate:	\$35,250.00
Implementation Priority:	4	Facility Function:	
Implementation Phase:		Implementation Date:	
Official Responsible:			
Notes:

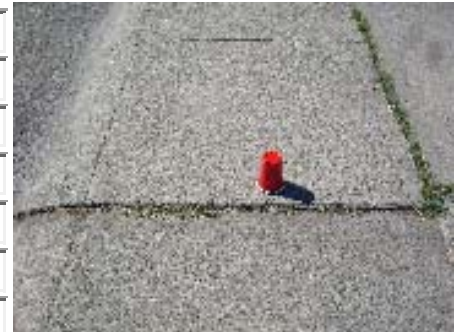
Field Date:	#####	Report Date:	10/15/2010	Barrier #:	735B
Location:	Tupelo Dr - North				
X Coordinate:	-121.31673				
Y Coordinate:	38.70219				
Barrier Area:	Sidewalks				
Barrier Type:	Abrupt Change in Level - > 1/2"				
Code Ref:	CBC 1133B.7.1 and ADA/ABA 303.3

As Built Meas:	4	Quantity:	LF
Description:	Change in level greater than 1/2"		
As Built Desc:	1" lip in sidewalk surface		
Solution:	Grind or repair sidewalk to remove trip hazard		
Bar. Severity:	1 Necessary	Cost Estimate:	\$1,000.00
Implementation Priority:	4	Facility Function:	
Implementation Phase:		Implementation Date:	
Official Responsible:			
Notes:

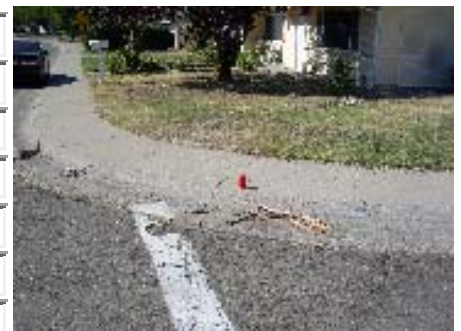
Field Date:	#####	Report Date:	10/15/2010	Barrier #:	736
Location:	Tupelo Dr and Stoneridge Wy - Corner A				
X Coordinate:	-121.31639				
Y Coordinate:	38.70242				
Barrier Area:	Curb Ramps				
Barrier Type:	No Curb Ramp				
Code Ref:	CBC 1127B.5.1 and ADA/ABA 402.2

As Built Meas:	1	Quantity:	EACH
Description:	No curb cut at corner (intersection)		
As Built Desc:	No curb ramp at corner		
Solution:	Demolish existing and construct curb cut		
Bar. Severity:	1 Necessary	Cost Estimate:	\$2,500.00
Implementation Priority:	4	Facility Function:	
Implementation Phase:		Implementation Date:	
Official Responsible:			
Notes:	Two - way intersection corners A,B

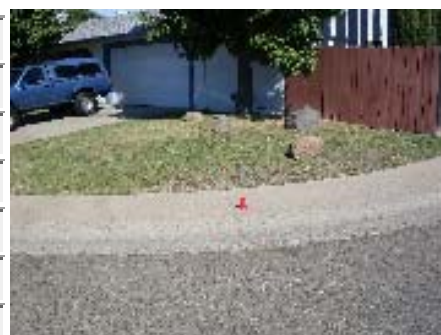
Barrier Type: No Curb Ramp

Code Ref: CBC 1127B.5.1 and ADA/ABA 402.2

As Built Meas: 1 Quantity: EACH

Description: No curb cut at corner (intersection)

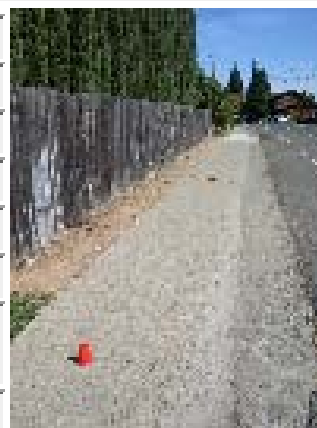
Barrier Type: Cross Slope - Existing (4.1% to 4.9%)

Code Ref: CBC 1133B.7.1.3 and ADA/ABA 403.3

As Built Meas: 778 Quantity: LF

Description: Cross slope exceeds 2.0% (4.1% to 4.9%)

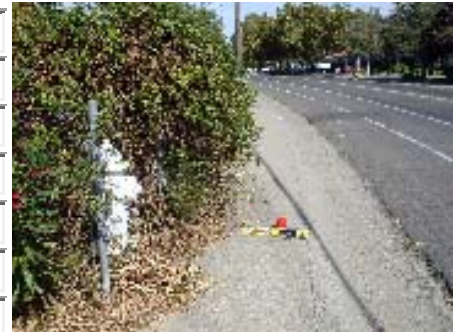
Barrier Type: Clear Width - Existing ($\leq 31"$ or less)

Code Ref: CBC 1133B.7.1

As Built Meas: 1 Quantity: LF

Description: Pedestrian route is not min. 48" wide ($\leq 31"$ or less)

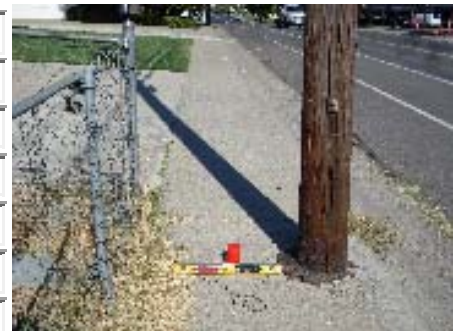
Barrier Type: Clear Width - Existing ($\leq 31"$ or less)

Code Ref: CBC 1133B.7.1

As Built Meas: 4 Quantity: LF

Description: Pedestrian route is not min. 48" wide ($\leq 31"$ or less)

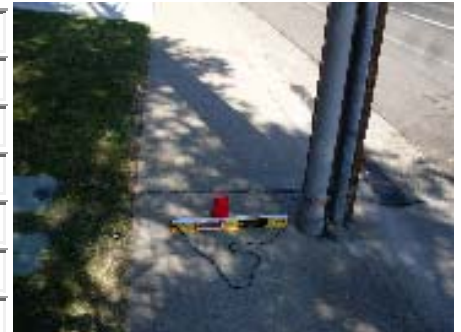
Barrier Type: Clear Width - Existing ($\leq 31"$ or less)

Code Ref: CBC 1133B.7.1

As Built Meas: 4 Quantity: LF

Description: Pedestrian route is not min. 48" wide ($\leq 31"$ or less)

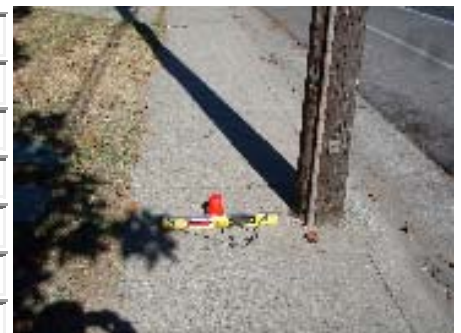
Barrier Type: Clear Width - Existing ($\leq 31"$ or less)

Code Ref: CBC 1133B.7.1

As Built Meas: 4 Quantity: LF

Description: Pedestrian route is not min. 48" wide ($\leq 31"$ or less)

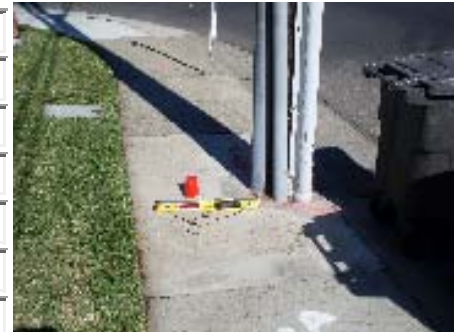
Barrier Type: Clear Width - Existing ($\leq 31"$ or less)

Code Ref: CBC 1133B.7.1

As Built Meas: 8 Quantity: LF

Description: Pedestrian route is not min. 48" wide ($\leq 31"$ or less)

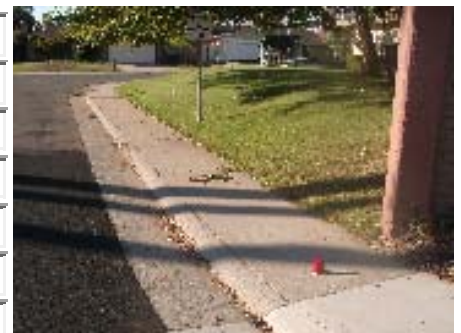
Barrier Type: Cross Slope - Existing (4.1% to 4.9%)

Code Ref: CBC 1133B.7.1.3 and ADA/ABA 403.3

As Built Meas: 82 Quantity: LF

Description: Cross slope exceeds 2.0% (4.1% to 4.9%)

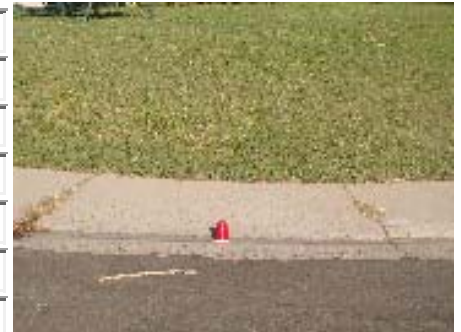
Field Date:	#####	Report Date:	10/15/2010	Barrier #:	740
Location:	Mango Tree Wy and Woodglade Ave - Corner A				
X Coordinate:	-121.32425				
Y Coordinate:	38.70683				
Barrier Area:	Curb Ramps				
Barrier Type:	No Curb Ramp - Depressed Exsiting Curb				
Code Ref:	CBC 1127B.5.1 and ADA/ABA 402.2

As Built Meas:	1	Quantity:	EACH
Description:	No compliant curb cut at corner (intersection)		
As Built Desc:	13.7% running slope at depressed area		
Solution:	Demolish existing and construct curb cut		
Bar. Severity:	1 Necessary	Cost Estimate:	\$2,500.00
Implementation Priority:	4	Facility Function:	
Implementation Phase:		Implementation Date:	
Official Responsible:			
Notes:	Two - way intersection corners A,B

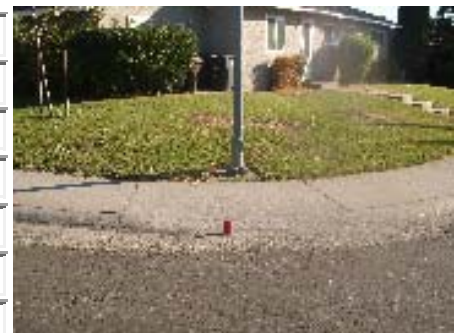
Field Date:	#####	Report Date:	10/15/2010	Barrier #:	741
Location:	Mango Tree Wy and Woodglade Ave - Corner B				
X Coordinate:	-121.32403				
Y Coordinate:	38.70683				
Barrier Area:	Curb Ramps				
Barrier Type:	No Curb Ramp - Depressed Exsiting Curb				
Code Ref:	CBC 1127B.5.1 and ADA/ABA 402.2

As Built Meas:	1	Quantity:	EACH
Description:	No compliant curb cut at corner (intersection)		
As Built Desc:	14.5% running slope at depressed area		
Solution:	Demolish existing and construct curb cut		
Bar. Severity:	1 Necessary	Cost Estimate:	\$2,500.00
Implementation Priority:	4	Facility Function:	
Implementation Phase:		Implementation Date:	
Official Responsible:			
Notes:	Two - way intersection corners A,B

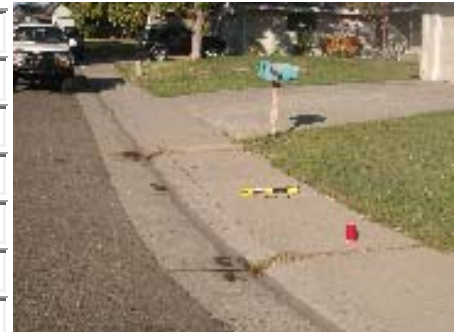
Field Date:	#####	Report Date:	10/15/2010	Barrier #:	742
Location:	Woodglade Ave - North				
X Coordinate:	-121.32429				
Y Coordinate:	38.70681				
Barrier Area:	Sidewalks				
Barrier Type:	Cross Slope - Existing (5.0% or more)				
Code Ref:	CBC 1133B.7.1.3 and ADA/ABA 403.3

As Built Meas:	345	Quantity:	LF
Description:	Cross slope exceeds 2.0% (5.0% or more)		
As Built Desc:	5.2% cross slope		
Solution:	Demolish existing and construct new route		
Bar. Severity:	1 Necessary	Cost Estimate:	\$43,125.00
Implementation Priority:	4	Facility Function:	
Implementation Phase:		Implementation Date:	
Official Responsible:			
Notes:

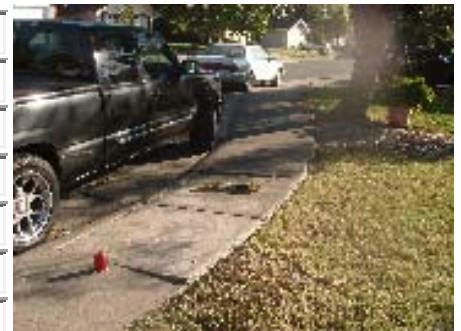
Field Date:	#####	Report Date:	10/15/2010	Barrier #:	743A
Location:	Woodbriar Wy - South				
X Coordinate:	-121.32535				
Y Coordinate:	38.70597				
Barrier Area:	Sidewalks				
Barrier Type:	Cross Slope - Existing (5.0% or more)				
Code Ref:	CBC 1133B.7.1.3 and ADA/ABA 403.3

As Built Meas:	41	Quantity:	LF
Description:	Cross slope exceeds 2.0% (5.0% or more)		
As Built Desc:	8.7% cross slope		
Solution:	Demolish existing and construct new route		
Bar. Severity:	1 Necessary	Cost Estimate:	\$5,125.00
Implementation Priority:	4	Facility Function:	
Implementation Phase:		Implementation Date:	
Official Responsible:			
Notes:

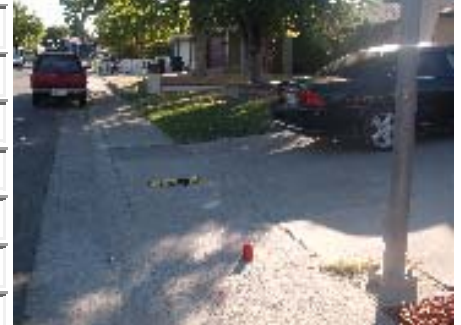
Field Date:	#####	Report Date:	10/15/2010	Barrier #:	744
Location:	Woodbriar Wy - South				
X Coordinate:	-121.32453				
Y Coordinate:	38.70604				
Barrier Area:	Sidewalks				
Barrier Type:	Cross Slope - Existing (5.0% or more)				
Code Ref:	CBC 1133B.7.1.3 and ADA/ABA 403.3

As Built Meas:	372	Quantity:	LF
Description:	Cross slope exceeds 2.0% (5.0% or more)		
As Built Desc:	5.1% cross slope		
Solution:	Demolish existing and construct new route		
Bar. Severity:	1 Necessary	Cost Estimate:	\$46,500.00
Implementation Priority:	4	Facility Function:	
Implementation Phase:		Implementation Date:	
Official Responsible:			
Notes:

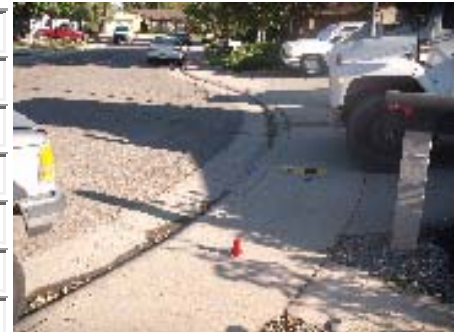
Field Date:	#####	Report Date:	10/15/2010	Barrier #:	745
Location:	Woodbriar Way - East				
X Coordinate:	-121.3232				
Y Coordinate:	38.70606				
Barrier Area:	Sidewalks				
Barrier Type:	Cross Slope - Existing (4.1% to 4.9%)				
Code Ref:	CBC 1133B.7.1.3 and ADA/ABA 403.3

As Built Meas:	211	Quantity:	LF
Description:	Cross slope exceeds 2.0% (4.1% to 4.9%)		
As Built Desc:	4.7% cross slope		
Solution:	Demolish existing and construct new route		
Bar. Severity:	2 Recommended	Cost Estimate:	\$26,375.00
Implementation Priority:	4	Facility Function:	
Implementation Phase:		Implementation Date:	
Official Responsible:

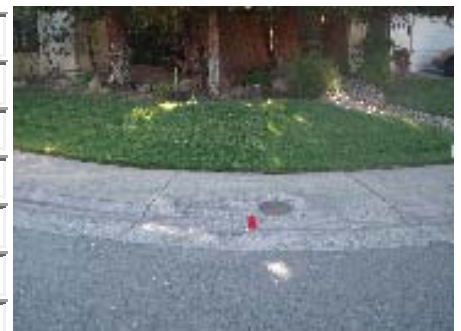
Field Date:	#####	Report Date:	10/15/2010	Barrier #:	746
Location:	Woodbriar Wy and Woodglade Ave - Corner C				
X Coordinate:	-121.32316				
Y Coordinate:	38.70665				
Barrier Area:	Curb Ramps				
Barrier Type:	No Curb Ramp - Depressed Existing Curb				
Code Ref:	CBC 1127B.5.1 and ADA/ABA 402.2

As Built Meas:	1	Quantity:	EACH
Description:	No compliant curb cut at corner (intersection)		
As Built Desc:	11.6% running slope at depressed area		
Solution:	Demolish existing and construct curb cut		
Bar. Severity:	1 Necessary	Cost Estimate:	\$2,500.00
Implementation Priority:	4	Facility Function:	
Implementation Phase:		Implementation Date:	
Official Responsible:

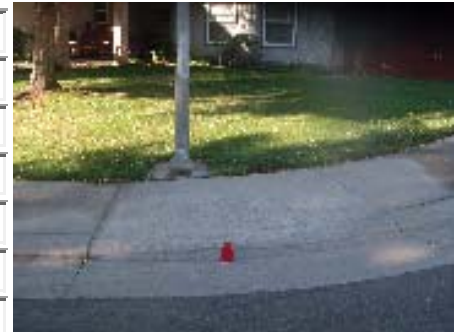
Field Date:	#####	Report Date:	10/15/2010	Barrier #:	747
Location:	Woodbriar Wy and Woodglade Ave - Corner D				
X Coordinate:	-121.32325				
Y Coordinate:	38.70667				
Barrier Area:	Curb Ramps				
Barrier Type:	No Curb Ramp - Depressed Exsiting Curb				
Code Ref:	CBC 1127B.5.1 and ADA/ABA 402.2

As Built Meas:	1	Quantity:	EACH
Description:	No compliant curb cut at corner (intersection)		
As Built Desc:	12.5% running slope at depressed area		
Solution:	Demolish existing and construct curb cut		
Bar. Severity:	1 Necessary	Cost Estimate:	\$2,500.00
Implementation Priority:	4	Facility Function:	
Implementation Phase:		Implementation Date:	
Official Responsible:			
Notes:	Two - way intersection corners C,D

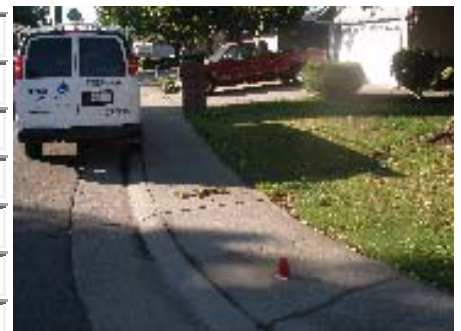
Field Date:	#####	Report Date:	10/15/2010	Barrier #:	748
Location:	Woodbriar Wy - West				
X Coordinate:	-121.32327				
Y Coordinate:	38.70665				
Barrier Area:	Sidewalks				
Barrier Type:	Cross Slope - Existing (5.0% or more)				
Code Ref:	CBC 1133B.7.1.3 and ADA/ABA 403.3

As Built Meas:	182	Quantity:	LF
Description:	Cross slope exceeds 2.0% (5.0% or more)		
As Built Desc:	5.4% cross slope		
Solution:	Demolish existing and construct new route		
Bar. Severity:	1 Necessary	Cost Estimate:	\$22,750.00
Implementation Priority:	4	Facility Function:	
Implementation Phase:		Implementation Date:	
Official Responsible:			
Notes:

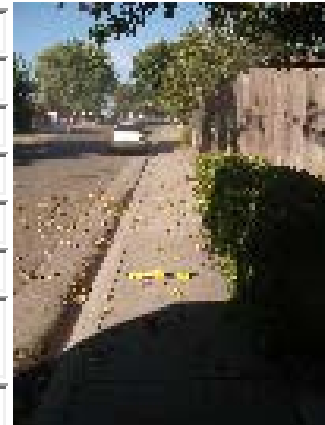
Field Date:	#####	Report Date:	10/15/2010	Barrier #:	749A
Location:	Woodbriar Wy - North				
X Coordinate:	-121.32331				
Y Coordinate:	38.70618				
Barrier Area:	Sidewalks				
Barrier Type:	Cross Slope - Existing (5.0% or more)				
Code Ref:	CBC 1133B.7.1.3 and ADA/ABA 403.3

As Built Meas:	356	Quantity:	LF		
Description:	Cross slope exceeds 2.0% (5.0% or more)				
As Built Desc:	5.2% cross slope				
Solution:	Demolish existing and construct new route				
Bar. Severity:	1 Necessary	Cost Estimate:	\$44,500.00	Status:	
Implementation Priority:	4	Facility Function:			
Implementation Phase:		Implementation Date:			
Official Responsible:					
Notes:

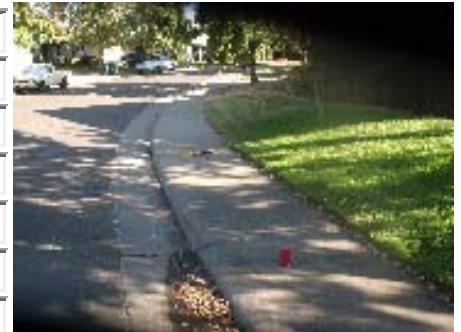
Field Date:	#####	Report Date:	10/15/2010	Barrier #:	750A
Location:	Woodbriar Wy - East				
X Coordinate:	-121.32544				
Y Coordinate:	38.7062				
Barrier Area:	Sidewalks				
Barrier Type:	Cross Slope - Existing (4.1% to 4.9%)				
Code Ref:	CBC 1133B.7.1.3 and ADA/ABA 403.3

As Built Meas:	602	Quantity:	LF
Description:	Cross slope exceeds 2.0% (4.1% to 4.9%)		
As Built Desc:	4.1% cross slope		
Solution:	Demolish existing and construct new route		
Bar. Severity:	2 Recommended	Cost Estimate:	\$75,250.00
Implementation Priority:	4	Facility Function:	
Implementation Phase:		Implementation Date:	
Official Responsible:			
Notes:

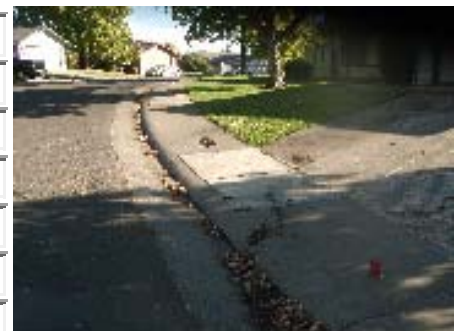
Field Date:	#####	Report Date:	10/15/2010	Barrier #:	750B
Location:	Woodbriar Wy - East				
X Coordinate:	-121.32536				
Y Coordinate:	38.7064				
Barrier Area:	Sidewalks				
Barrier Type:	Running Slope (New Construction)				
Code Ref:	CBC 1133B.7.3 and ADA/ABA 403.3

As Built Meas:	30	Quantity:	LF
Description:	Running slope exceeds 5.0% where roadway slope does not		
As Built Desc:	6.7% running slope		
Solution:	Demolish existing and construct new route		
Bar. Severity:	1 Necessary	Cost Estimate:	\$3,750.00
Implementation Priority:	4	Facility Function:	
Implementation Phase:		Implementation Date:	
Official Responsible:			
Notes:

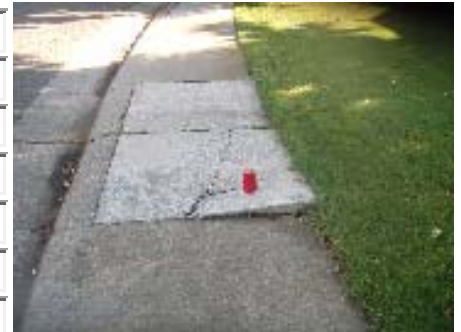
Barrier Type: Abrupt Change in Level - Tree Heaves

As Built Meas: 4 Quantity: LF

Description: Change in level greater than 1/2"

Solution: Grind or repair sidewalk to remove trip hazard

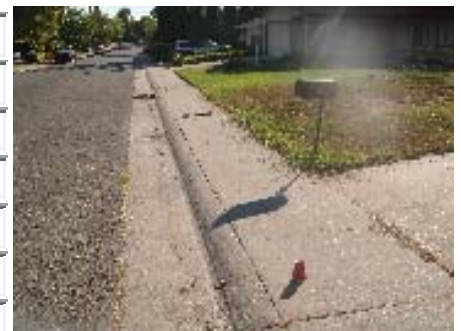
Barrier Type: Cross Slope - Existing (5.0% or more)

As Built Meas: 266 Quantity: LF

Description: Cross slope exceeds 2.0% (5.0% or more)

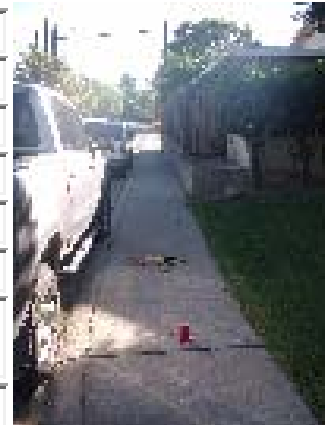
Field Date:	#####	Report Date:	10/15/2010	Barrier #:	752A
Location:	Woodglade Ave - South				
X Coordinate:	-121.3231				
Y Coordinate:	38.70665				
Barrier Area:	Sidewalks				
Barrier Type:	Cross Slope - Existing (4.1% to 4.9%)				
Code Ref:	CBC 1133B.7.1.3 and ADA/ABA 403.3

As Built Meas:	322	Quantity:	LF		
Description:	Cross slope exceeds 2.0% (4.1% to 4.9%)				
As Built Desc:	4.1% cross slope				
Solution:	Demolish existing and construct new route				
Bar. Severity:	2 Recommended	Cost Estimate:	\$40,250.00	Status:	
Implementation Priority:	4	Facility Function:			
Implementation Phase:		Implementation Date:			
Official Responsible:

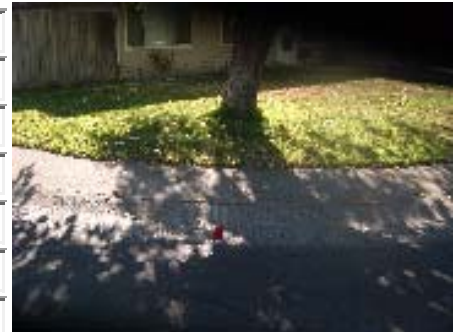
Field Date:	#####	Report Date:	10/15/2010	Barrier #:	753
Location:	Blackthorne Wy and Woodglade Ave - Corner C				
X Coordinate:	-121.3218				
Y Coordinate:	38.70668				
Barrier Area:	Curb Ramps				
Barrier Type:	No Curb Ramp				
Code Ref:	CBC 1127B.5.1 and ADA/ABA 402.2

As Built Meas:	1	Quantity:	EACH
Description:	No curb cut at corner (intersection)		
As Built Desc:	No curb ramp at corner		
Solution:	Demolish existing and construct curb cut		
Bar. Severity:	1 Necessary	Cost Estimate:	\$2,500.00
Implementation Priority:	4	Facility Function:	
Implementation Phase:		Implementation Date:	
Official Responsible:			
Notes:	Two - way intersection corners C,D

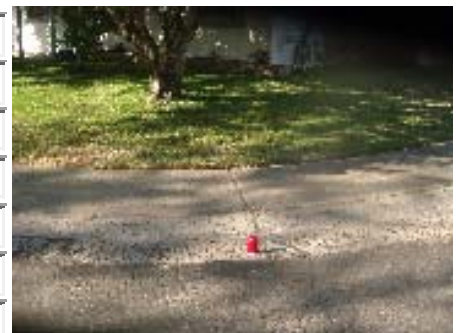
Field Date:	#####	Report Date:	10/15/2010	Barrier #:	754
Location:	Blackthorne Wy and Woodglade Ave - Corner D				
X Coordinate:	-121.32194				
Y Coordinate:	38.70664				
Barrier Area:	Curb Ramps				
Barrier Type:	No Curb Ramp				
Code Ref:	CBC 1127B.5.1 and ADA/ABA 402.2

As Built Meas:	1	Quantity:	EACH
Description:	No curb cut at corner (intersection)		
As Built Desc:	No curb ramp at corner		
Solution:	Demolish existing and construct curb cut		
Bar. Severity:	1 Necessary	Cost Estimate:	\$2,500.00
Implementation Priority:	4	Facility Function:	
Implementation Phase:		Implementation Date:	
Official Responsible:			
Notes:	Two - way intersection corners C,D

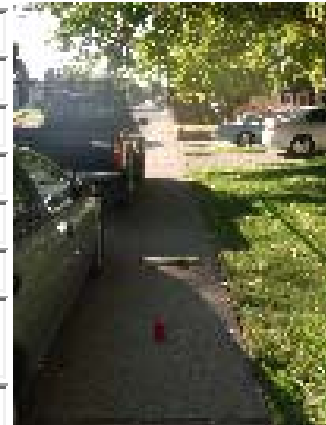
Barrier Type: Cross Slope - Existing (5.0% or more)

As Built Meas: 221 Quantity: LF

Description: Cross slope exceeds 2.0% (5.0% or more)

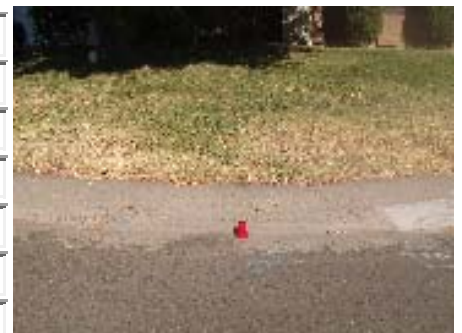
Barrier Type: No Curb Ramp - Depressed Existing Curb

As Built Meas: 1 Quantity: EACH

Description: No compliant curb cut at corner (intersection)

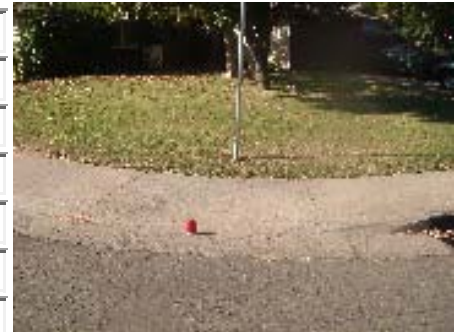
Field Date:	#####	Report Date:	10/15/2010	Barrier #:	757
Location:	Blackthorne Wy and Len Ct - Corner D				
X Coordinate:	-121.32194				
Y Coordinate:	38.70595				
Barrier Area:	Curb Ramps				
Barrier Type:	No Curb Ramp - Depressed Exsiting Curb				
Code Ref:	CBC 1127B.5.1 and ADA/ABA 402.2

As Built Meas:	1	Quantity:	EACH
Description:	No compliant curb cut at corner (intersection)		
As Built Desc:	10.7% running slope at depressed area		
Solution:	Demolish existing and construct curb cut		
Bar. Severity:	1 Necessary	Cost Estimate:	\$2,500.00
Implementation Priority:	4	Facility Function:	
Implementation Phase:		Implementation Date:	
Official Responsible:			
Notes:	Two - way intersection corners A,D

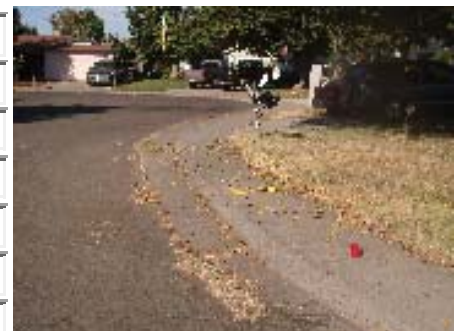
Field Date:	#####	Report Date:	10/15/2010	Barrier #:	758
Location:	Len Ct - North				
X Coordinate:	-121.322				
Y Coordinate:	38.70604				
Barrier Area:	Sidewalks				
Barrier Type:	Cross Slope - Existing (4.1% to 4.9%)				
Code Ref:	CBC 1133B.7.1.3 and ADA/ABA 403.3

As Built Meas:	150	Quantity:	LF
Description:	Cross slope exceeds 2.0% (4.1% to 4.9%)		
As Built Desc:	4.8% cross slope		
Solution:	Demolish existing and construct new route		
Bar. Severity:	2 Recommended	Cost Estimate:	\$18,750.00
Implementation Priority:	4	Facility Function:	
Implementation Phase:		Implementation Date:	
Official Responsible:			
Notes:

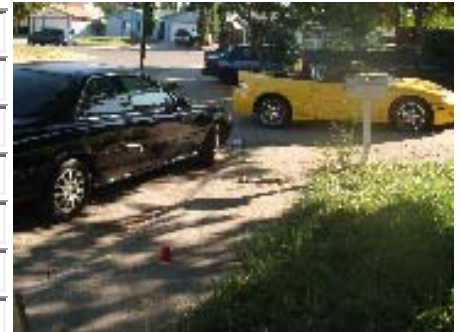
Field Date:	#####	Report Date:	10/15/2010	Barrier #:	759
Location:	Len Ct - South				
X Coordinate:	-121.32232				
Y Coordinate:	38.70587				
Barrier Area:	Sidewalks				
Barrier Type:	Cross Slope - Existing (5.0% or more)				
Code Ref:	CBC 1133B.7.1.3 and ADA/ABA 403.3

As Built Meas:	262	Quantity:	LF
Description:	Cross slope exceeds 2.0% (5.0% or more)		
As Built Desc:	5.0% cross slope		
Solution:	Demolish existing and construct new route		
Bar. Severity:	1 Necessary	Cost Estimate:	\$32,750.00
Implementation Priority:	4	Facility Function:	
Implementation Phase:		Implementation Date:	
Official Responsible:			
Notes:

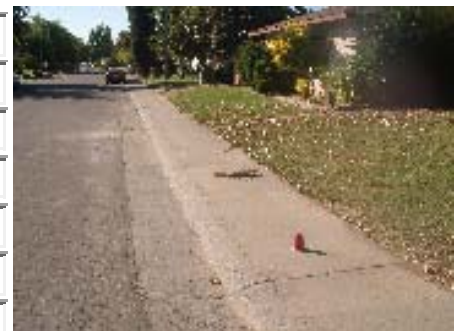
Field Date:	#####	Report Date:	10/15/2010	Barrier #:	760
Location:	Blackthorne Wy - West				
X Coordinate:	-121.32191				
Y Coordinate:	38.70589				
Barrier Area:	Sidewalks				
Barrier Type:	Cross Slope - Existing (5.0% or more)				
Code Ref:	CBC 1133B.7.1.3 and ADA/ABA 403.3

As Built Meas:	675	Quantity:	LF
Description:	Cross slope exceeds 2.0% (5.0% or more)		
As Built Desc:	5.6% cross slope		
Solution:	Demolish existing and construct new route		
Bar. Severity:	1 Necessary	Cost Estimate:	\$84,375.00
Implementation Priority:	4	Facility Function:	
Implementation Phase:		Implementation Date:	
Official Responsible:			
Notes:
