DRAFT ADA TRANSITION PLAN UPDATE
NEIGHBORHOOD AREA 1 NORTHWEST
SEPTEMBER 20, 2011

CITY OF CITRUS HEIGHTS

The Northwest Neighborhood Association

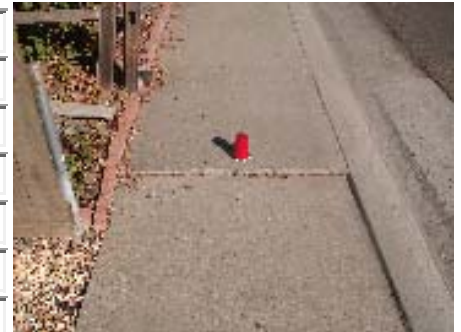
Field Date:	#####	Report Date:	10/15/2010	Barrier #:	761
Location:	Blackthorne Wy - West				
X Coordinate:	-121.32191				
Y Coordinate:	38.70588				
Barrier Area:	Sidewalks				
Barrier Type:	Abrupt Change in Level - > 1/2"				
Code Ref:	CBC 1133B.7.1 and ADA/ABA 303.3

As Built Meas:	4	Quantity:	LF		
Description:	Change in level greater than 1/2"				
As Built Desc:	1/2" lip in sidewalk surface				
Solution:	Grind or repair sidewalk to remove trip hazard				
Bar. Severity:	1 Necessary	Cost Estimate:	\$1,000.00	Status:	
Implementation Priority:	4	Facility Function:			
Implementation Phase:		Implementation Date:			
Official Responsible:					
Notes:

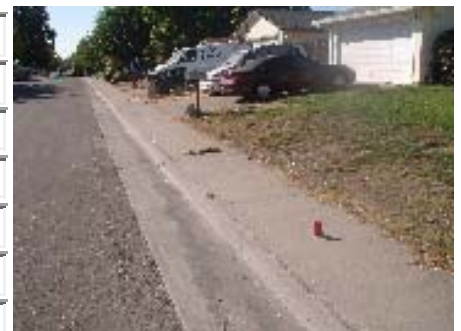
Field Date:	#####	Report Date:	10/15/2010	Barrier #:	762
Location:	Blackthorne Wy - West				
X Coordinate:	-121.32179				
Y Coordinate:	38.70385				
Barrier Area:	Sidewalks				
Barrier Type:	Cross Slope - Existing (5.0% or more)				
Code Ref:	CBC 1133B.7.1.3 and ADA/ABA 403.3

As Built Meas:	654	Quantity:	LF		
Description:	Cross slope exceeds 2.0% (5.0% or more)				
As Built Desc:	5.5% cross slope				
Solution:	Demolish existing and construct new route				
Bar. Severity:	1 Necessary	Cost Estimate:	\$81,750.00	Status:	
Implementation Priority:	4	Facility Function:			
Implementation Phase:		Implementation Date:			
Official Responsible:					
Notes:

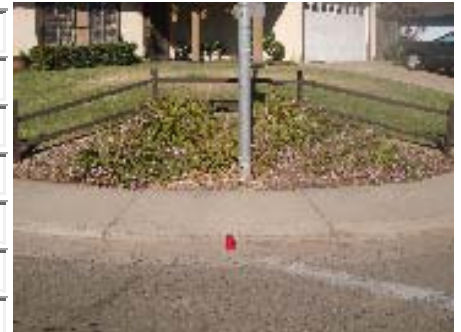
Field Date:	#####	Report Date:	10/15/2010	Barrier #:	763
Location:	Blackthorne Wy and Birchglade Wy - Corner A				
X Coordinate:	-121.32133				
Y Coordinate:	38.70205				
Barrier Area:	Curb Ramps				
Barrier Type:	No Curb Ramp - Depressed Exsiting Curb				
Code Ref:	CBC 1127B.5.1 and ADA/ABA 402.2

As Built Meas:	1	Quantity:	EACH
Description:	No compliant curb cut at corner (intersection)		
As Built Desc:	13.5% running slope at depressed area		
Solution:	Demolish existing and construct curb cut		
Bar. Severity:	1 Necessary	Cost Estimate:	\$2,500.00
Implementation Priority:	4	Facility Function:	
Implementation Phase:		Implementation Date:	
Official Responsible:			
Notes:	Four - way intersection corners A,B,C,D

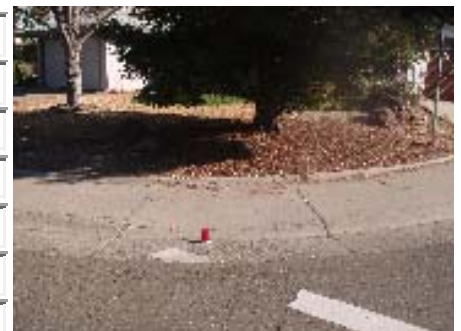
Field Date:	#####	Report Date:	10/15/2010	Barrier #:	764
Location:	Blackthorne Wy and Birchglade Wy - Corner B				
X Coordinate:	-121.3212				
Y Coordinate:	38.70208				
Barrier Area:	Curb Ramps				
Barrier Type:	No Curb Ramp - Depressed Exsiting Curb				
Code Ref:	CBC 1127B.5.1 and ADA/ABA 402.2

As Built Meas:	1	Quantity:	EACH
Description:	No compliant curb cut at corner (intersection)		
As Built Desc:	16.7% running slope at depressed area		
Solution:	Demolish existing and construct curb cut		
Bar. Severity:	1 Necessary	Cost Estimate:	\$2,500.00
Implementation Priority:	4	Facility Function:	
Implementation Phase:		Implementation Date:	
Official Responsible:			
Notes:	Four - way intersection corners A,B,C,D

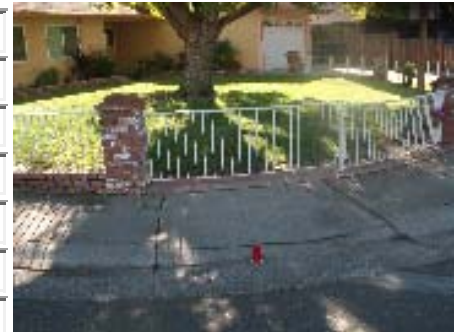
Field Date:	#####	Report Date:	10/15/2010	Barrier #:	765
Location:	Blackthorne Wy and Birchglade Wy - Corner C				
X Coordinate:	-121.32115				
Y Coordinate:	38.70195				
Barrier Area:	Curb Ramps				
Barrier Type:	No Curb Ramp - Depressed Exsiting Curb				
Code Ref:	CBC 1127B.5.1 and ADA/ABA 402.2

As Built Meas:	1	Quantity:	EACH
Description:	No compliant curb cut at corner (intersection)		
As Built Desc:	15.9% running slope at depressed area		
Solution:	Demolish existing and construct curb cut		
Bar. Severity:	1 Necessary	Cost Estimate:	\$2,500.00
Implementation Priority:	4	Facility Function:	
Implementation Phase:		Implementation Date:	
Official Responsible:			
Notes:	Four - way intersection corners A,B,C,D

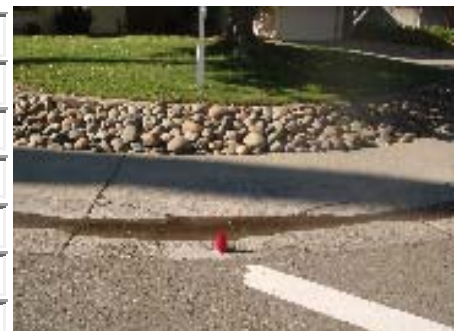
Field Date:	#####	Report Date:	10/15/2010	Barrier #:	766
Location:	Blackthorne Wy and Birchglade Wy - Corner D				
X Coordinate:	-121.32132				
Y Coordinate:	38.70193				
Barrier Area:	Curb Ramps				
Barrier Type:	No Curb Ramp - Depressed Exsiting Curb				
Code Ref:	CBC 1127B.5.1 and ADA/ABA 402.2

As Built Meas:	1	Quantity:	EACH
Description:	No compliant curb cut at corner (intersection)		
As Built Desc:	15.1% running slope at depressed area		
Solution:	Demolish existing and construct curb cut		
Bar. Severity:	1 Necessary	Cost Estimate:	\$2,500.00
Implementation Priority:	4	Facility Function:	
Implementation Phase:		Implementation Date:	
Official Responsible:			
Notes:	Four - way intersection corners A,B,C,D

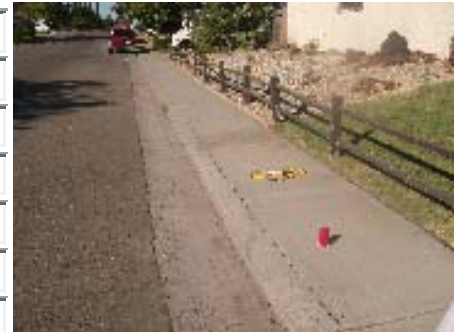
Field Date:	#####	Report Date:	10/15/2010	Barrier #:	767
Location:	Birchglade Wy - North				
X Coordinate:	-121.32142				
Y Coordinate:	38.70203				
Barrier Area:	Sidewalks				
Barrier Type:	Cross Slope - Existing (5.0% or more)				
Code Ref:	CBC 1133B.7.1.3 and ADA/ABA 403.3

As Built Meas:	511	Quantity:	LF
Description:	Cross slope exceeds 2.0% (5.0% or more)		
As Built Desc:	6.3% cross slope		
Solution:	Demolish existing and construct new route		
Bar. Severity:	1 Necessary	Cost Estimate:	\$63,875.00
Implementation Priority:	4	Facility Function:	
Implementation Phase:		Implementation Date:	
Official Responsible:

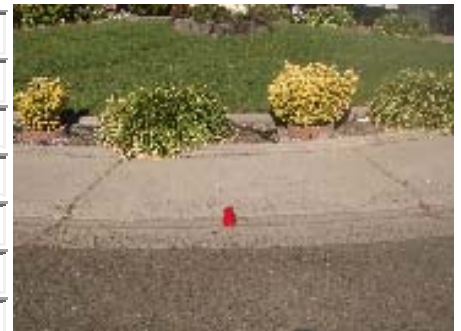
Field Date:	#####	Report Date:	10/15/2010	Barrier #:	768
Location:	Birchglade Wy and Rigging Ct - Corner A				
X Coordinate:	-121.32346				
Y Coordinate:	38.70178				
Barrier Area:	Curb Ramps				
Barrier Type:	No Curb Ramp - Depressed Existing Curb				
Code Ref:	CBC 1127B.5.1 and ADA/ABA 402.2

As Built Meas:	1	Quantity:	EACH
Description:	No compliant curb cut at corner (intersection)		
As Built Desc:	9.0% running slope at depressed area		
Solution:	Demolish existing and construct curb cut		
Bar. Severity:	1 Necessary	Cost Estimate:	\$2,500.00
Implementation Priority:	4	Facility Function:	
Implementation Phase:		Implementation Date:	
Official Responsible:

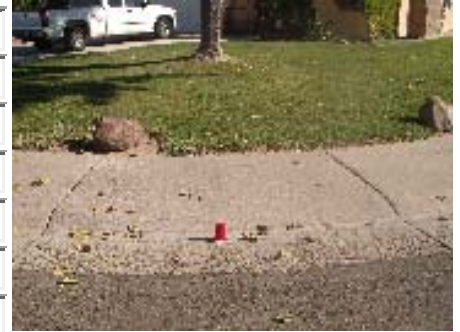
Field Date:	#####	Report Date:	10/15/2010	Barrier #:	769
Location:	Birchglade Wy and Rigging Ct - Corner B				
X Coordinate:	-121.32319				
Y Coordinate:	38.70181				
Barrier Area:	Curb Ramps				
Barrier Type:	No Curb Ramp - Depressed Exsiting Curb				
Code Ref:	CBC 1127B.5.1 and ADA/ABA 402.2

As Built Meas:	1	Quantity:	EACH
Description:	No compliant curb cut at corner (intersection)		
As Built Desc:	12.5% running slope at depressed area		
Solution:	Demolish existing and construct curb cut		
Bar. Severity:	1 Necessary	Cost Estimate:	\$2,500.00
Implementation Priority:	4	Facility Function:	
Implementation Phase:		Implementation Date:	
Official Responsible:			
Notes:	Two - way intersection corners A,B

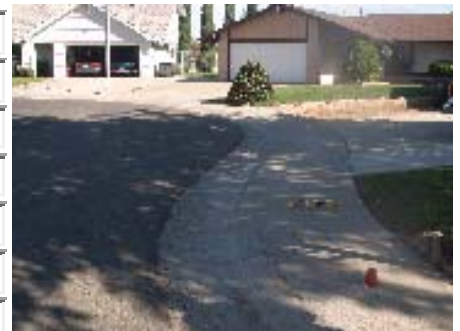
Field Date:	#####	Report Date:	10/15/2010	Barrier #:	770
Location:	Rigging Ct - East				
X Coordinate:	-121.32324				
Y Coordinate:	38.70183				
Barrier Area:	Sidewalks				
Barrier Type:	Cross Slope - Existing (5.0% or more)				
Code Ref:	CBC 1133B.7.1.3 and ADA/ABA 403.3

As Built Meas:	102	Quantity:	LF
Description:	Cross slope exceeds 2.0% (5.0% or more)		
As Built Desc:	5.2% cross slope		
Solution:	Demolish existing and construct new route		
Bar. Severity:	1 Necessary	Cost Estimate:	\$12,750.00
Implementation Priority:	4	Facility Function:	
Implementation Phase:		Implementation Date:	
Official Responsible:			
Notes:

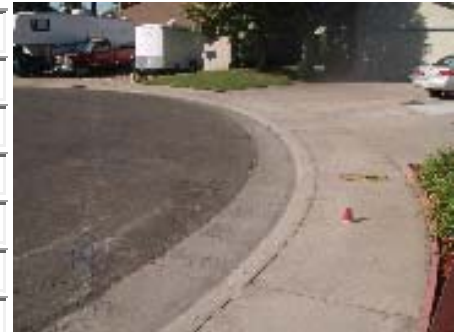
Field Date:	#####	Report Date:	10/15/2010	Barrier #:	771
Location:	Rigging Ct - West				
X Coordinate:	-121.32337				
Y Coordinate:	38.70202				
Barrier Area:	Sidewalks				
Barrier Type:	Cross Slope - Existing (5.0% or more)				
Code Ref:	CBC 1133B.7.1.3 and ADA/ABA 403.3

As Built Meas:	119	Quantity:	LF
Description:	Cross slope exceeds 2.0% (5.0% or more)		
As Built Desc:	5.0% cross slope		
Solution:	Demolish existing and construct new route		
Bar. Severity:	1 Necessary	Cost Estimate:	\$14,875.00
Implementation Priority:	4	Facility Function:	
Implementation Phase:		Implementation Date:	
Official Responsible:			
Notes:

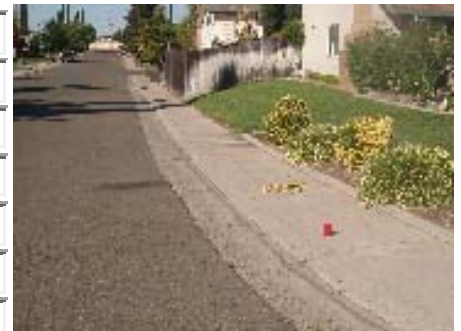
Field Date:	#####	Report Date:	10/15/2010	Barrier #:	772
Location:	Birchglade Wy - North				
X Coordinate:	-121.32346				
Y Coordinate:	38.70171				
Barrier Area:	Sidewalks				
Barrier Type:	Cross Slope - Existing (5.0% or more)				
Code Ref:	CBC 1133B.7.1.3 and ADA/ABA 403.3

As Built Meas:	220	Quantity:	LF
Description:	Cross slope exceeds 2.0% (5.0% or more)		
As Built Desc:	5.1% cross slope		
Solution:	Demolish existing and construct new route		
Bar. Severity:	1 Necessary	Cost Estimate:	\$27,500.00
Implementation Priority:	4	Facility Function:	
Implementation Phase:		Implementation Date:	
Official Responsible:			
Notes:

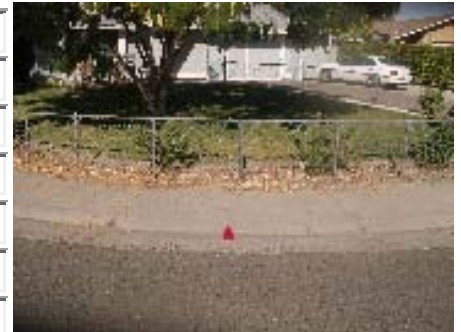
Field Date:	#####	Report Date:	10/15/2010	Barrier #:	773
Location:	Birchglade Wy and Ketch Ct - Corner A				
X Coordinate:	-121.32446				
Y Coordinate:	38.70175				
Barrier Area:	Curb Ramps				
Barrier Type:	No Curb Ramp - Depressed Exsiting Curb				
Code Ref:	CBC 1127B.5.1 and ADA/ABA 402.2

As Built Meas:	1	Quantity:	EACH
Description:	No compliant curb cut at corner (intersection)		
As Built Desc:	9.7% running slope at depressed area		
Solution:	Demolish existing and construct curb cut		
Bar. Severity:	1 Necessary	Cost Estimate:	\$2,500.00
Implementation Priority:	4	Facility Function:	
Implementation Phase:		Implementation Date:	
Official Responsible:			
Notes:	Two - way intersection corners A,B

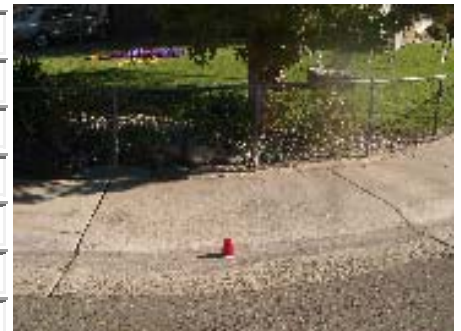
Field Date:	#####	Report Date:	10/15/2010	Barrier #:	774
Location:	Birchglade Wy and Ketch Ct - Corner B				
X Coordinate:	-121.3243				
Y Coordinate:	38.70171				
Barrier Area:	Curb Ramps				
Barrier Type:	No Curb Ramp - Depressed Exsiting Curb				
Code Ref:	CBC 1127B.5.1 and ADA/ABA 402.2

As Built Meas:	1	Quantity:	EACH
Description:	No compliant curb cut at corner (intersection)		
As Built Desc:	9.0% running slope at depressed area		
Solution:	Demolish existing and construct curb cut		
Bar. Severity:	1 Necessary	Cost Estimate:	\$2,500.00
Implementation Priority:	4	Facility Function:	
Implementation Phase:		Implementation Date:	
Official Responsible:			
Notes:	Two - way intersection corners A,B

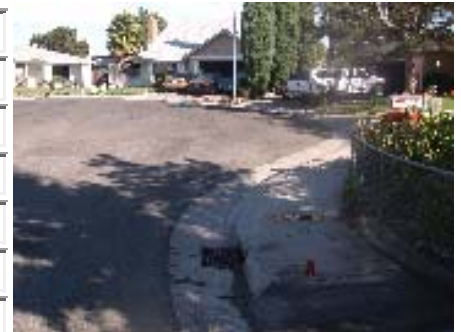
Field Date:	#####	Report Date:	10/15/2010	Barrier #:	775
Location:	Ketch Ct - East				
X Coordinate:	-121.32431				
Y Coordinate:	38.70177				
Barrier Area:	Sidewalks				
Barrier Type:	Cross Slope - Existing (4.1% to 4.9%)				
Code Ref:	CBC 1133B.7.1.3 and ADA/ABA 403.3

As Built Meas:	123	Quantity:	LF
Description:	Cross slope exceeds 2.0% (4.1% to 4.9%)		
As Built Desc:	4.4% cross slope		
Solution:	Demolish existing and construct new route		
Bar. Severity:	2 Recommended	Cost Estimate:	\$15,375.00
Implementation Priority:	4	Facility Function:	
Implementation Phase:		Implementation Date:	
Official Responsible:			
Notes:

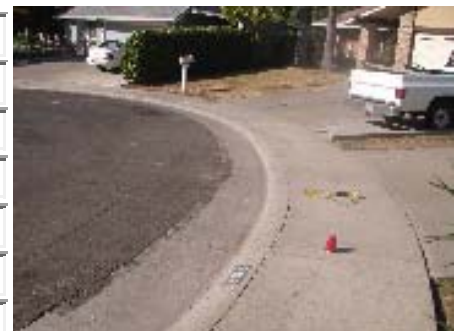
Field Date:	#####	Report Date:	10/15/2010	Barrier #:	776
Location:	Ketch Ct - West				
X Coordinate:	-121.3244				
Y Coordinate:	38.70201				
Barrier Area:	Sidewalks				
Barrier Type:	Cross Slope - Existing (5.0% or more)				
Code Ref:	CBC 1133B.7.1.3 and ADA/ABA 403.3

As Built Meas:	123	Quantity:	LF
Description:	Cross slope exceeds 2.0% (5.0% or more)		
As Built Desc:	5.2% cross slope		
Solution:	Demolish existing and construct new route		
Bar. Severity:	1 Necessary	Cost Estimate:	\$15,375.00
Implementation Priority:	4	Facility Function:	
Implementation Phase:		Implementation Date:	
Official Responsible:			
Notes:

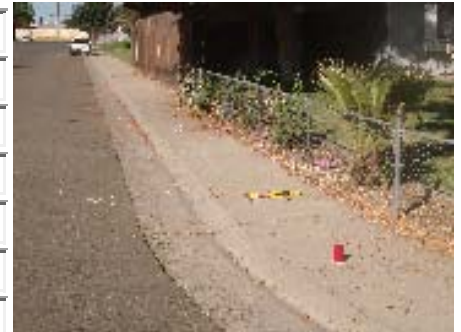
Field Date:	#####	Report Date:	10/15/2010	Barrier #:	777
Location:	Birchglade Wy - North				
X Coordinate:	-121.32444				
Y Coordinate:	38.7017				
Barrier Area:	Sidewalks				
Barrier Type:	Cross Slope - Existing (5.0% or more)				
Code Ref:	CBC 1133B.7.1.3 and ADA/ABA 403.3

As Built Meas:	215	Quantity:	LF
Description:	Cross slope exceeds 2.0% (5.0% or more)		
As Built Desc:	5.0% cross slope		
Solution:	Demolish existing and construct new route		
Bar. Severity:	1 Necessary	Cost Estimate:	\$26,875.00
Implementation Priority:	4	Facility Function:	
Implementation Phase:		Implementation Date:	
Official Responsible:

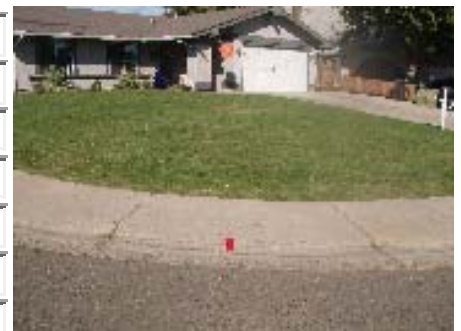
Field Date:	#####	Report Date:	10/15/2010	Barrier #:	778
Location:	Birchglade Wy and Sloop Ct -Corner A				
X Coordinate:	-121.32543				
Y Coordinate:	38.70173				
Barrier Area:	Curb Ramps				
Barrier Type:	No Curb Ramp - Depressed Existing Curb				
Code Ref:	CBC 1127B.5.1 and ADA/ABA 402.2

As Built Meas:	1	Quantity:	EACH
Description:	No compliant curb cut at corner (intersection)		
As Built Desc:	11.8% running slope at depressed area		
Solution:	Demolish existing and construct curb cut		
Bar. Severity:	1 Necessary	Cost Estimate:	\$2,500.00
Implementation Priority:	4	Facility Function:	
Implementation Phase:		Implementation Date:	
Official Responsible:

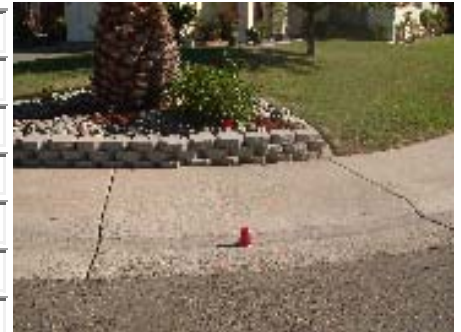
Field Date:	#####	Report Date:	10/15/2010	Barrier #:	779
Location:	Birchglade Wy and Sloop Ct -Corner B				
X Coordinate:	-121.32526				
Y Coordinate:	38.70172				
Barrier Area:	Curb Ramps				
Barrier Type:	No Curb Ramp - Depressed Exsiting Curb				
Code Ref:	CBC 1127B.5.1 and ADA/ABA 402.2

As Built Meas:	1	Quantity:	EACH
Description:	No compliant curb cut at corner (intersection)		
As Built Desc:	11.1% running slope at depressed area		
Solution:	Demolish existing and construct curb cut		
Bar. Severity:	1 Necessary	Cost Estimate:	\$2,500.00
Implementation Priority:	4	Facility Function:	
Implementation Phase:		Implementation Date:	
Official Responsible:			
Notes:	Two - way intersection corners A,B

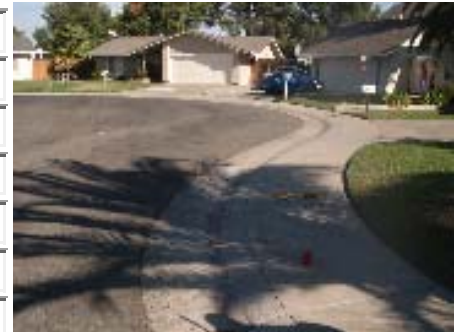
Field Date:	#####	Report Date:	10/15/2010	Barrier #:	781
Location:	Sloop Ct - East				
X Coordinate:	-121.32529				
Y Coordinate:	38.70177				
Barrier Area:	Sidewalks				
Barrier Type:	Cross Slope - Existing (4.1% to 4.9%)				
Code Ref:	CBC 1133B.7.1.3 and ADA/ABA 403.3

As Built Meas:	109	Quantity:	LF
Description:	Cross slope exceeds 2.0% (4.1% to 4.9%)		
As Built Desc:	4.6% cross slope		
Solution:	Demolish existing and construct new route		
Bar. Severity:	2 Recommended	Cost Estimate:	\$13,625.00
Implementation Priority:	4	Facility Function:	
Implementation Phase:		Implementation Date:	
Official Responsible:

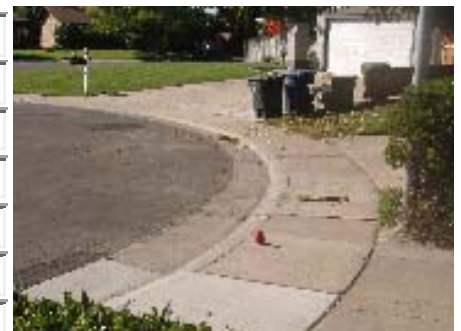
Field Date:	#####	Report Date:	10/15/2010	Barrier #:	782
Location:	Sloop Ct - West				
X Coordinate:	-121.32543				
Y Coordinate:	38.70198				
Barrier Area:	Sidewalks				
Barrier Type:	Cross Slope - Existing (5.0% or more)				
Code Ref:	CBC 1133B.7.1.3 and ADA/ABA 403.3

As Built Meas:	104	Quantity:	LF
Description:	Cross slope exceeds 2.0% (5.0% or more)		
As Built Desc:	5.0% cross slope		
Solution:	Demolish existing and construct new route		
Bar. Severity:	1 Necessary	Cost Estimate:	\$13,000.00
Implementation Priority:	4	Facility Function:	
Implementation Phase:		Implementation Date:	
Official Responsible:

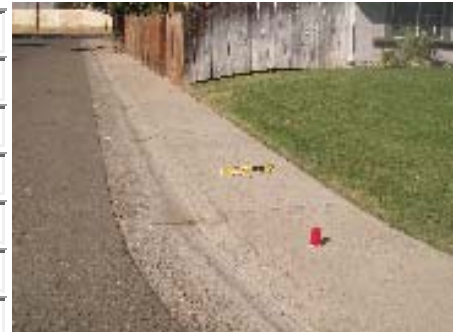
Field Date:	#####	Report Date:	10/15/2010	Barrier #:	783
Location:	Birchglade Wy - North				
X Coordinate:	-121.32551				
Y Coordinate:	38.7017				
Barrier Area:	Sidewalks				
Barrier Type:	Cross Slope - Existing (5.0% or more)				
Code Ref:	CBC 1133B.7.1.3 and ADA/ABA 403.3

As Built Meas:	204	Quantity:	LF
Description:	Cross slope exceeds 2.0% (5.0% or more)		
As Built Desc:	5.6% cross slope		
Solution:	Demolish existing and construct new route		
Bar. Severity:	1 Necessary	Cost Estimate:	\$25,500.00
Implementation Priority:	4	Facility Function:	
Implementation Phase:		Implementation Date:	
Official Responsible:			
Notes:

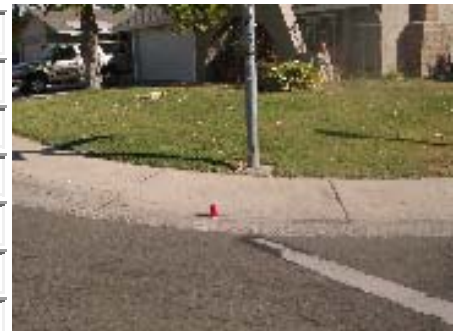
Field Date:	#####	Report Date:	10/15/2010	Barrier #:	784
Location:	Birchglade Wy and Daly Ave - Corner B				
X Coordinate:	-121.32624				
Y Coordinate:	38.70173				
Barrier Area:	Curb Ramps				
Barrier Type:	No Curb Ramp - Depressed Existing Curb				
Code Ref:	CBC 1127B.5.1 and ADA/ABA 402.2

As Built Meas:	1	Quantity:	EACH
Description:	No compliant curb cut at corner (intersection)		
As Built Desc:	9.5% running slope at depressed area		
Solution:	Demolish existing and construct curb cut		
Bar. Severity:	1 Necessary	Cost Estimate:	\$2,500.00
Implementation Priority:	4	Facility Function:	
Implementation Phase:		Implementation Date:	
Official Responsible:			
Notes:	Two - way intersection corners B,C

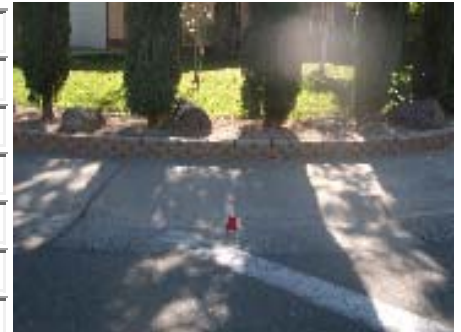
Field Date:	#####	Report Date:	10/15/2010	Barrier #:	785
Location:	Birchglade Wy and Daly Ave - Corner C				
X Coordinate:	-121.32625				
Y Coordinate:	38.70154				
Barrier Area:	Curb Ramps				
Barrier Type:	No Curb Ramp - Depressed Exsiting Curb				
Code Ref:	CBC 1127B.5.1 and ADA/ABA 402.2

As Built Meas:	1	Quantity:	EACH
Description:	No compliant curb cut at corner (intersection)		
As Built Desc:	9.7% running slope at depressed area		
Solution:	Demolish existing and construct curb cut		
Bar. Severity:	1 Necessary	Cost Estimate:	\$2,500.00
Implementation Priority:	4	Facility Function:	
Implementation Phase:		Implementation Date:	
Official Responsible:			
Notes:	Two - way intersection corners B,C

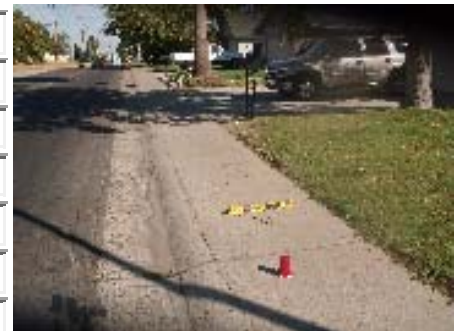
Field Date:	#####	Report Date:	10/15/2010	Barrier #:	786
Location:	Daly Ave - East				
X Coordinate:	-121.32626				
Y Coordinate:	38.70181				
Barrier Area:	Sidewalks				
Barrier Type:	Cross Slope - Existing (5.0% or more)				
Code Ref:	CBC 1133B.7.1.3 and ADA/ABA 403.3

As Built Meas:	285	Quantity:	LF
Description:	Cross slope exceeds 2.0% (5.0% or more)		
As Built Desc:	5.2% cross slope		
Solution:	Demolish existing and construct new route		
Bar. Severity:	1 Necessary	Cost Estimate:	\$35,625.00
Implementation Priority:	4	Facility Function:	
Implementation Phase:		Implementation Date:	
Official Responsible:			
Notes:

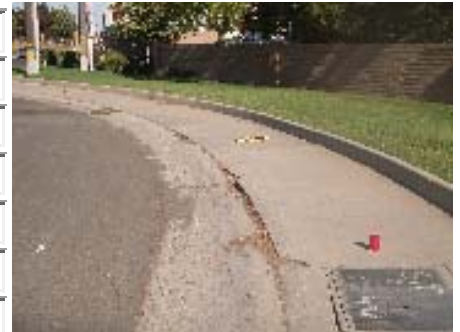
Field Date:	#####	Report Date:	10/15/2010	Barrier #:	787
Location:	Daly Ave - East				
X Coordinate:	-121.32619				
Y Coordinate:	38.70545				
Barrier Area:	Sidewalks				
Barrier Type:	Cross Slope - Existing (4.1% to 4.9%)				
Code Ref:	CBC 1133B.7.1.3 and ADA/ABA 403.3

As Built Meas:	58	Quantity:	LF
Description:	Cross slope exceeds 2.0% (4.1% to 4.9%)		
As Built Desc:	4.1% cross slope		
Solution:	Demolish existing and construct new route		
Bar. Severity:	2 Recommended	Cost Estimate:	\$7,250.00
Implementation Priority:	4	Facility Function:	
Implementation Phase:		Implementation Date:	
Official Responsible:

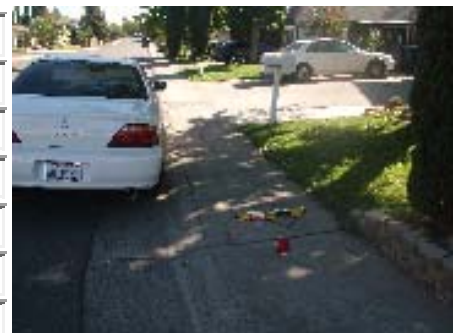
Field Date:	#####	Report Date:	10/15/2010	Barrier #:	788
Location:	Birchglade Wy - South				
X Coordinate:	-121.32621				
Y Coordinate:	38.70156				
Barrier Area:	Sidewalks				
Barrier Type:	Cross Slope - Existing (5.0% or more)				
Code Ref:	CBC 1133B.7.1.3 and ADA/ABA 403.3

As Built Meas:	1397	Quantity:	LF
Description:	Cross slope exceeds 2.0% (5.0% or more)		
As Built Desc:	5.1% cross slope		
Solution:	Demolish existing and construct new route		
Bar. Severity:	1 Necessary	Cost Estimate:	\$174,625.00
Implementation Priority:	4	Facility Function:	
Implementation Phase:		Implementation Date:	
Official Responsible:

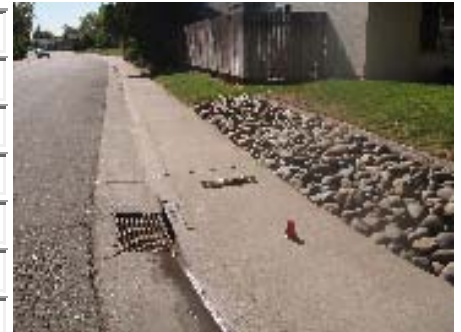
Field Date:	#####	Report Date:	10/15/2010	Barrier #:	789
Location:	Blackthorn Wy - West				
X Coordinate:	-121.32127				
Y Coordinate:	38.70187				
Barrier Area:	Sidewalks				
Barrier Type:	Cross Slope - Existing (5.0% or more)				
Code Ref:	CBC 1133B.7.1.3 and ADA/ABA 403.3

As Built Meas:	182	Quantity:	LF
Description:	Cross slope exceeds 2.0% (5.0% or more)		
As Built Desc:	5.3% cross slope		
Solution:	Demolish existing and construct new route		
Bar. Severity:	1 Necessary	Cost Estimate:	\$22,750.00
Implementation Priority:	4	Facility Function:	
Implementation Phase:		Implementation Date:	
Official Responsible:			
Notes:

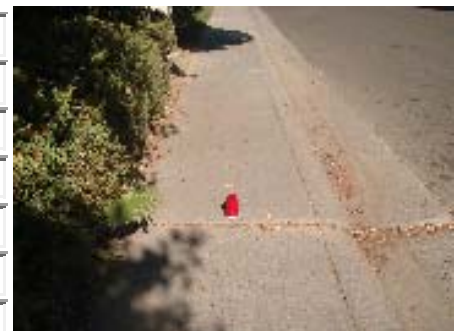
Field Date:	#####	Report Date:	10/15/2010	Barrier #:	790
Location:	Blackthorn Wy - West				
X Coordinate:	-121.32118				
Y Coordinate:	38.70164				
Barrier Area:	Sidewalks				
Barrier Type:	Abrupt Change in Level - > 1/2"				
Code Ref:	CBC 1133B.7.1 and ADA/ABA 303.3

As Built Meas:	4	Quantity:	LF
Description:	Change in level greater than 1/2"		
As Built Desc:	1/2" lip in sidewalk surface		
Solution:	Grind or repair sidewalk to remove trip hazard		
Bar. Severity:	1 Necessary	Cost Estimate:	\$1,000.00
Implementation Priority:	4	Facility Function:	
Implementation Phase:		Implementation Date:	
Official Responsible:			
Notes:

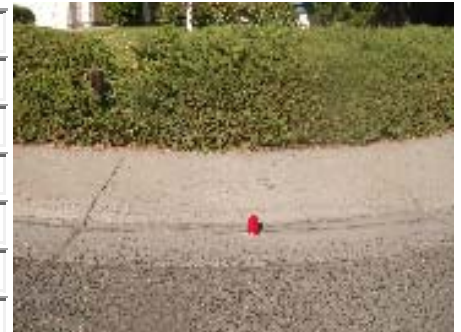
Field Date:	#####	Report Date:	10/15/2010	Barrier #:	791
Location:	Blackthorn Wy and Miravale Ct - Corner A				
X Coordinate:	-121.32116				
Y Coordinate:	38.70132				
Barrier Area:	Curb Ramps				
Barrier Type:	No Curb Ramp - Depressed Exsiting Curb				
Code Ref:	CBC 1127B.5.1 and ADA/ABA 402.2

As Built Meas:	1	Quantity:	EACH
Description:	No compliant curb cut at corner (intersection)		
As Built Desc:	15.4% running slope at depressed area		
Solution:	Demolish existing and construct curb cut		
Bar. Severity:	1 Necessary	Cost Estimate:	\$2,500.00
Implementation Priority:	4	Facility Function:	
Implementation Phase:		Implementation Date:	
Official Responsible:			
Notes:	Two - way intersection corners A,D

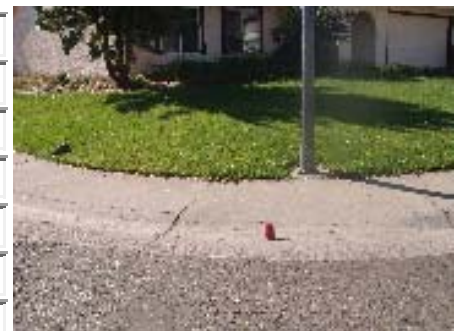
Field Date:	#####	Report Date:	10/15/2010	Barrier #:	792
Location:	Blackthorn Wy and Miravale Ct - Corner D				
X Coordinate:	-121.32111				
Y Coordinate:	38.7012				
Barrier Area:	Curb Ramps				
Barrier Type:	No Curb Ramp - Depressed Exsiting Curb				
Code Ref:	CBC 1127B.5.1 and ADA/ABA 402.2

As Built Meas:	1	Quantity:	EACH
Description:	No compliant curb cut at corner (intersection)		
As Built Desc:	14.7% running slope at depressed area		
Solution:	Demolish existing and construct curb cut		
Bar. Severity:	1 Necessary	Cost Estimate:	\$2,500.00
Implementation Priority:	4	Facility Function:	
Implementation Phase:		Implementation Date:	
Official Responsible:			
Notes:	Two - way intersection corners A,D

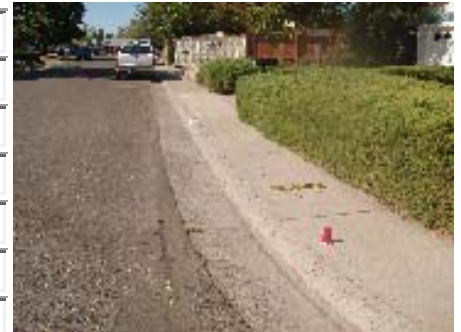
Field Date:	#####	Report Date:	10/15/2010	Barrier #:	793A
Location:	Miravale Ct - North				
X Coordinate:	-121.32122				
Y Coordinate:	38.70132				
Barrier Area:	Sidewalks				
Barrier Type:	Cross Slope - Existing (5.0% or more)				
Code Ref:	CBC 1133B.7.1.3 and ADA/ABA 403.3

As Built Meas:	413	Quantity:	LF
Description:	Cross slope exceeds 2.0% (5.0% or more)		
As Built Desc:	5.9% cross slope		
Solution:	Demolish existing and construct new route		
Bar. Severity:	1 Necessary	Cost Estimate:	\$51,625.00
Implementation Priority:	4	Facility Function:	
Implementation Phase:		Implementation Date:	
Official Responsible:			
Notes:

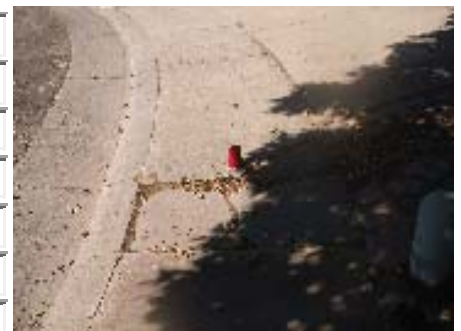
Field Date:	#####	Report Date:	10/15/2010	Barrier #:	793B
Location:	Miravale Ct - North				
X Coordinate:	-121.32233				
Y Coordinate:	38.70116				
Barrier Area:	Sidewalks				
Barrier Type:	Surface Condition - Damaged				
Code Ref:	CBC 1133B.7.1 and ADA/ABA 302.1

As Built Meas:	4	Quantity:	LF
Description:	Surface is not firm and stable (cracked, broken or loose soil, etc.)		
As Built Desc:	Cracked concrete		
Solution:	Repair surface to make firm and stable		
Bar. Severity:	1 Necessary	Cost Estimate:	\$500.00
Implementation Priority:	4	Facility Function:	
Implementation Phase:		Implementation Date:	
Official Responsible:			
Notes:

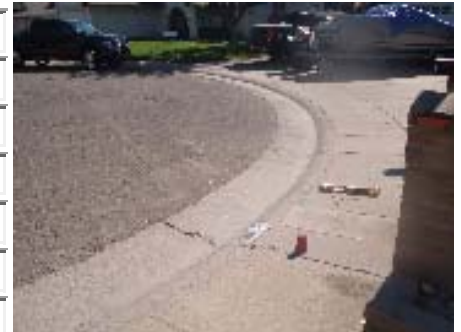
Field Date:	#####	Report Date:	10/15/2010	Barrier #:	794
Location:	Miravale Ct - South				
X Coordinate:	-121.32245				
Y Coordinate:	38.70095				
Barrier Area:	Sidewalks				
Barrier Type:	Cross Slope - Existing (5.0% or more)				
Code Ref:	CBC 1133B.7.1.3 and ADA/ABA 403.3

As Built Meas:	399	Quantity:	LF		
Description:	Cross slope exceeds 2.0% (5.0% or more)				
As Built Desc:	5.7% cross slope				
Solution:	Demolish existing and construct new route				
Bar. Severity:	1 Necessary	Cost Estimate:	\$49,875.00	Status:	
Implementation Priority:	4	Facility Function:			
Implementation Phase:		Implementation Date:			
Official Responsible:					
Notes:

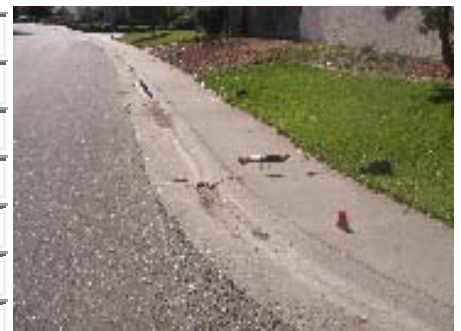
Field Date:	#####	Report Date:	10/15/2010	Barrier #:	795
Location:	Blackthorn Wy - West				
X Coordinate:	-121.32109				
Y Coordinate:	38.7012				
Barrier Area:	Sidewalks				
Barrier Type:	Cross Slope - Existing (5.0% or more)				
Code Ref:	CBC 1133B.7.1.3 and ADA/ABA 403.3

As Built Meas:	581	Quantity:	LF		
Description:	Cross slope exceeds 2.0% (5.0% or more)				
As Built Desc:	6.2% cross slope				
Solution:	Demolish existing and construct new route				
Bar. Severity:	1 Necessary	Cost Estimate:	\$72,625.00	Status:	
Implementation Priority:	4	Facility Function:			
Implementation Phase:		Implementation Date:			
Official Responsible:					
Notes:

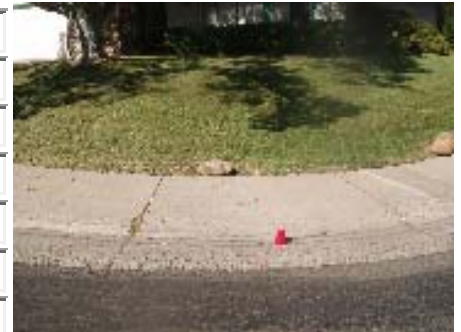
Field Date:	#####	Report Date:	10/15/2010	Barrier #:	796
Location:	Blackthorn Wy and Springvale Wy - Corner A				
X Coordinate:	-121.32086				
Y Coordinate:	38.70068				
Barrier Area:	Curb Ramps				
Barrier Type:	No Curb Ramp - Depressed Exsiting Curb				
Code Ref:	CBC 1127B.5.1 and ADA/ABA 402.2

As Built Meas:	1	Quantity:	EACH
Description:	No compliant curb cut at corner (intersection)		
As Built Desc:	14.2% running slope at depressed area		
Solution:	Demolish existing and construct curb cut		
Bar. Severity:	1 Necessary	Cost Estimate:	\$2,500.00
Implementation Priority:	4	Facility Function:	
Implementation Phase:		Implementation Date:	
Official Responsible:			
Notes:	Two - way intersection corners A,D

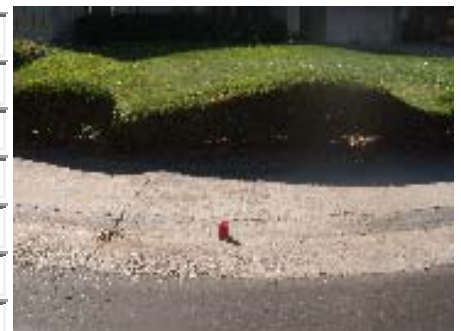
Field Date:	#####	Report Date:	10/15/2010	Barrier #:	797
Location:	Blackthorn Wy and Springvale Wy - Corner D				
X Coordinate:	-121.32079				
Y Coordinate:	38.70062				
Barrier Area:	Curb Ramps				
Barrier Type:	No Curb Ramp - Depressed Exsiting Curb				
Code Ref:	CBC 1127B.5.1 and ADA/ABA 402.2

As Built Meas:	1	Quantity:	EACH
Description:	No compliant curb cut at corner (intersection)		
As Built Desc:	13.1% running slope at depressed area		
Solution:	Demolish existing and construct curb cut		
Bar. Severity:	1 Necessary	Cost Estimate:	\$2,500.00
Implementation Priority:	4	Facility Function:	
Implementation Phase:		Implementation Date:	
Official Responsible:			
Notes:	Two - way intersection corners A,D

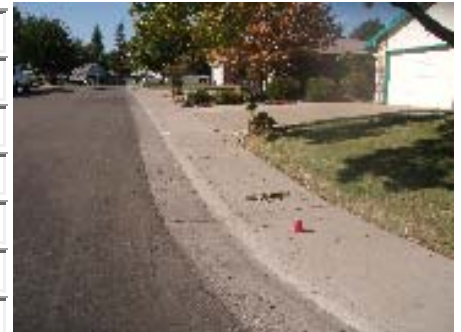
Field Date:	#####	Report Date:	10/15/2010	Barrier #:	798
Location:	Springvale Wy - North				
X Coordinate:	-121.32088				
Y Coordinate:	38.7007				
Barrier Area:	Sidewalks				
Barrier Type:	Cross Slope - Existing (5.0% or more)				
Code Ref:	CBC 1133B.7.1.3 and ADA/ABA 403.3

As Built Meas:	456	Quantity:	LF
Description:	Cross slope exceeds 2.0% (5.0% or more)		
As Built Desc:	5.9% cross slope		
Solution:	Demolish existing and construct new route		
Bar. Severity:	1 Necessary	Cost Estimate:	\$57,000.00
Implementation Priority:	4	Facility Function:	
Implementation Phase:		Implementation Date:	
Official Responsible:

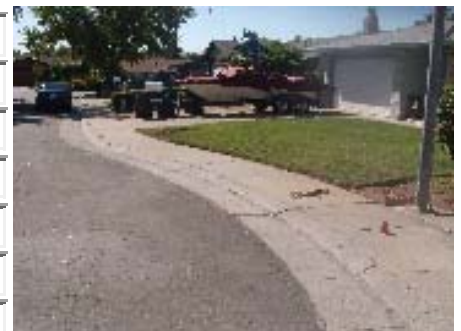
Field Date:	#####	Report Date:	10/15/2010	Barrier #:	799
Location:	Springvale Wy - West				
X Coordinate:	-121.32247				
Y Coordinate:	38.70022				
Barrier Area:	Sidewalks				
Barrier Type:	Cross Slope - Existing (5.0% or more)				
Code Ref:	CBC 1133B.7.1.3 and ADA/ABA 403.3

As Built Meas:	172	Quantity:	LF
Description:	Cross slope exceeds 2.0% (5.0% or more)		
As Built Desc:	6.2% cross slope		
Solution:	Demolish existing and construct new route		
Bar. Severity:	1 Necessary	Cost Estimate:	\$21,500.00
Implementation Priority:	4	Facility Function:	
Implementation Phase:		Implementation Date:	
Official Responsible:

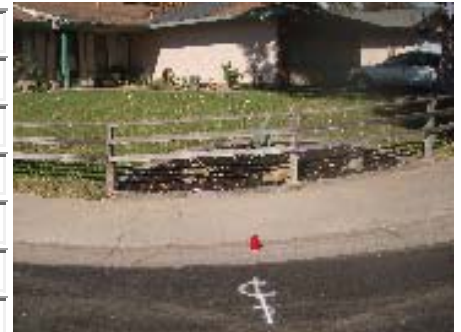
Field Date:	#####	Report Date:	10/15/2010	Barrier #:	800
Location:	Springvale Wy and Parkvale Wy - Corner A				
X Coordinate:	-121.32249				
Y Coordinate:	38.69971				
Barrier Area:	Curb Ramps				
Barrier Type:	No Curb Ramp - Depressed Exsiting Curb				
Code Ref:	CBC 1127B.5.1 and ADA/ABA 402.2

As Built Meas:	1	Quantity:	EACH
Description:	No compliant curb cut at corner (intersection)		
As Built Desc:	15.3% running slope at depressed area		
Solution:	Demolish existing and construct curb cut		
Bar. Severity:	1 Necessary	Cost Estimate:	\$2,500.00
Implementation Priority:	4	Facility Function:	
Implementation Phase:		Implementation Date:	
Official Responsible:			
Notes:	Two - way intersection corners A,B

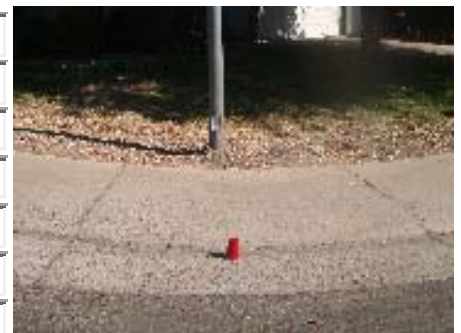
Field Date:	#####	Report Date:	10/15/2010	Barrier #:	801
Location:	Springvale Wy and Parkvale Wy - Corner B				
X Coordinate:	-121.32236				
Y Coordinate:	38.69966				
Barrier Area:	Curb Ramps				
Barrier Type:	No Curb Ramp - Depressed Exsiting Curb				
Code Ref:	CBC 1127B.5.1 and ADA/ABA 402.2

As Built Meas:	1	Quantity:	EACH
Description:	No compliant curb cut at corner (intersection)		
As Built Desc:	14.9% running slope at depressed area		
Solution:	Demolish existing and construct curb cut		
Bar. Severity:	1 Necessary	Cost Estimate:	\$2,500.00
Implementation Priority:	4	Facility Function:	
Implementation Phase:		Implementation Date:	
Official Responsible:			
Notes:	Two - way intersection corners A,B

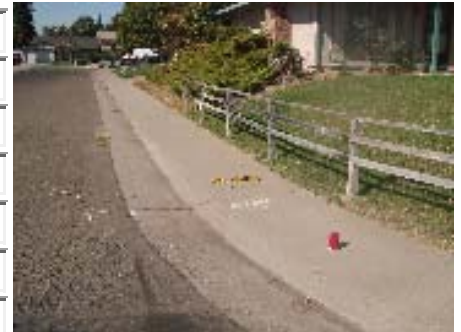
Field Date:	#####	Report Date:	10/15/2010	Barrier #:	802
Location:	Parkvale Wy - North				
X Coordinate:	-121.32252				
Y Coordinate:	38.69968				
Barrier Area:	Sidewalks				
Barrier Type:	Cross Slope - Existing (5.0% or more)				
Code Ref:	CBC 1133B.7.1.3 and ADA/ABA 403.3

As Built Meas:	263	Quantity:	LF
Description:	Cross slope exceeds 2.0% (5.0% or more)		
As Built Desc:	5.1% cross slope		
Solution:	Demolish existing and construct new route		
Bar. Severity:	1 Necessary	Cost Estimate:	\$32,875.00
Implementation Priority:	4	Facility Function:	
Implementation Phase:		Implementation Date:	
Official Responsible:			
Notes:

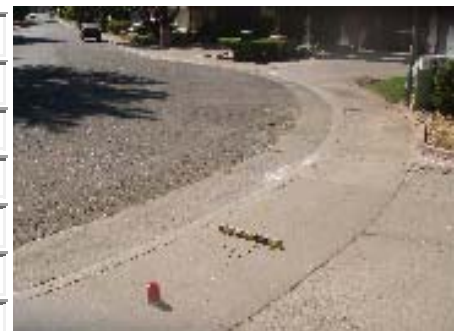
Field Date:	#####	Report Date:	10/15/2010	Barrier #:	803
Location:	Parkvale Wy - West				
X Coordinate:	-121.32344				
Y Coordinate:	38.69965				
Barrier Area:	Sidewalks				
Barrier Type:	Cross Slope - Existing (4.1% to 4.9%)				
Code Ref:	CBC 1133B.7.1.3 and ADA/ABA 403.3

As Built Meas:	242	Quantity:	LF
Description:	Cross slope exceeds 2.0% (4.1% to 4.9%)		
As Built Desc:	4.6% cross slope		
Solution:	Demolish existing and construct new route		
Bar. Severity:	2 Recommended	Cost Estimate:	\$30,250.00
Implementation Priority:	4	Facility Function:	
Implementation Phase:		Implementation Date:	
Official Responsible:			
Notes:

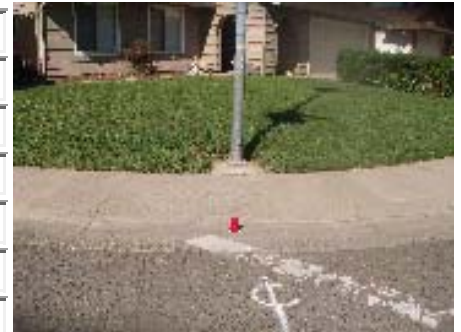
Field Date:	#####	Report Date:	10/15/2010	Barrier #:	804
Location:	Parkvale Wy and Tupelo Dr - Corner A				
X Coordinate:	-121.32356				
Y Coordinate:	38.69897				
Barrier Area:	Curb Ramps				
Barrier Type:	No Curb Ramp - Depressed Exsiting Curb				
Code Ref:	CBC 1127B.5.1 and ADA/ABA 402.2

As Built Meas:	1	Quantity:	EACH		
Description:	No compliant curb cut at corner (intersection)				
As Built Desc:	13.4% running slope at depressed area				
Solution:	Demolish existing and construct curb cut				
Bar. Severity:	1 Necessary	Cost Estimate:	\$2,500.00	Status:	
Implementation Priority:	4	Facility Function:			
Implementation Phase:		Implementation Date:			
Official Responsible:					
Notes:	Four - way intersection corners A,B,C,D

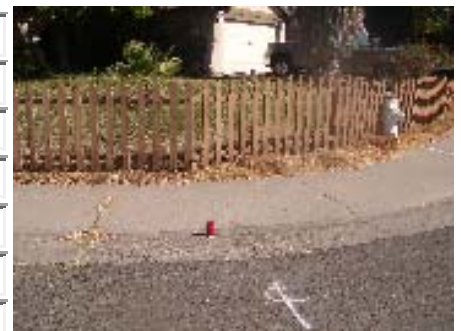
Field Date:	#####	Report Date:	10/15/2010	Barrier #:	805
Location:	Parkvale Wy and Tupelo Dr - Corner B				
X Coordinate:	-121.32338				
Y Coordinate:	38.69897				
Barrier Area:	Curb Ramps				
Barrier Type:	No Curb Ramp - Depressed Exsiting Curb				
Code Ref:	CBC 1127B.5.1 and ADA/ABA 402.2

As Built Meas:	1	Quantity:	EACH		
Description:	No compliant curb cut at corner (intersection)				
As Built Desc:	12.7% running slope at depressed area				
Solution:	Demolish existing and construct curb cut				
Bar. Severity:	1 Necessary	Cost Estimate:	\$2,500.00	Status:	
Implementation Priority:	4	Facility Function:			
Implementation Phase:		Implementation Date:			
Official Responsible:					
Notes:	Four - way intersection corners A,B,C,D

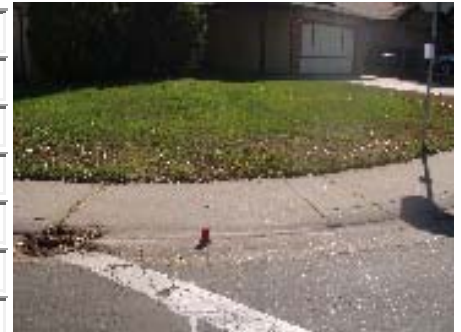
Field Date:	#####	Report Date:	10/15/2010	Barrier #:	806
Location:	Parkvale Wy and Tupelo Dr - Corner C				
X Coordinate:	-121.32334				
Y Coordinate:	38.69881				
Barrier Area:	Curb Ramps				
Barrier Type:	No Curb Ramp - Depressed Exsiting Curb				
Code Ref:	CBC 1127B.5.1 and ADA/ABA 402.2

As Built Meas:	1	Quantity:	EACH
Description:	No compliant curb cut at corner (intersection)		
As Built Desc:	12.9% running slope at depressed area		
Solution:	Demolish existing and construct curb cut		
Bar. Severity:	1 Necessary	Cost Estimate:	\$2,500.00
Implementation Priority:	4	Facility Function:	
Implementation Phase:		Implementation Date:	
Official Responsible:			
Notes:	Four - way intersection corners A,B,C,D

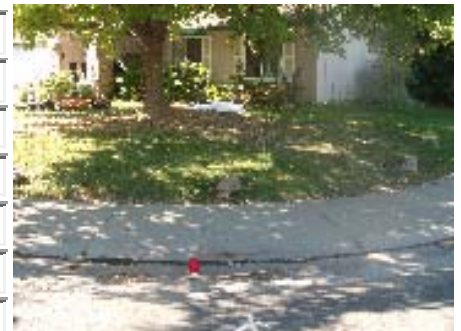
Field Date:	#####	Report Date:	10/15/2010	Barrier #:	807
Location:	Parkvale Wy and Tupelo Dr - Corner D				
X Coordinate:	-121.32354				
Y Coordinate:	38.69883				
Barrier Area:	Curb Ramps				
Barrier Type:	No Curb Ramp - Depressed Exsiting Curb				
Code Ref:	CBC 1127B.5.1 and ADA/ABA 402.2

As Built Meas:	1	Quantity:	EACH
Description:	No compliant curb cut at corner (intersection)		
As Built Desc:	14.1% running slope at depressed area		
Solution:	Demolish existing and construct curb cut		
Bar. Severity:	1 Necessary	Cost Estimate:	\$2,500.00
Implementation Priority:	4	Facility Function:	
Implementation Phase:		Implementation Date:	
Official Responsible:			
Notes:	Four - way intersection corners A,B,C,D

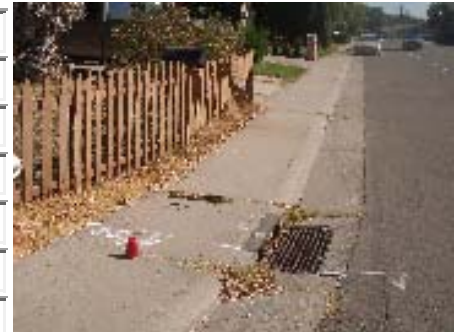
Field Date:	#####	Report Date:	10/15/2010	Barrier #:	808
Location:	Tupelo Dr - North				
X Coordinate:	-121.32331				
Y Coordinate:	38.69898				
Barrier Area:	Sidewalks				
Barrier Type:	Cross Slope - Existing (5.0% or more)				
Code Ref:	CBC 1133B.7.1.3 and ADA/ABA 403.3

As Built Meas:	487	Quantity:	LF	
Description:	Cross slope exceeds 2.0% (5.0% or more)			
As Built Desc:	5.9% cross slope			
Solution:	Demolish existing and construct new route			
Bar. Severity:	1 Necessary	Cost Estimate:	\$60,875.00	Status:
Implementation Priority:	4	Facility Function:		
Implementation Phase:		Implementation Date:		
Official Responsible:				
Notes:

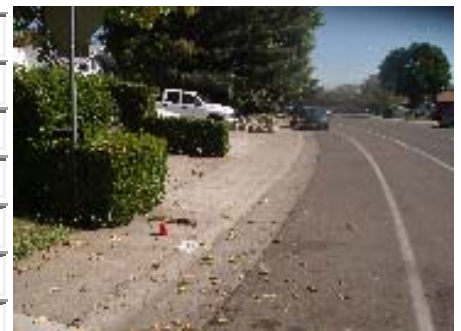
Field Date:	#####	Report Date:	10/15/2010	Barrier #:	809
Location:	Tupelo Dr - North				
X Coordinate:	-121.32153				
Y Coordinate:	38.69901				
Barrier Area:	Sidewalks				
Barrier Type:	Cross Slope - Existing (4.1% to 4.9%)				
Code Ref:	CBC 1133B.7.1.3 and ADA/ABA 403.3

As Built Meas:	231	Quantity:	LF	
Description:	Cross slope exceeds 2.0% (4.1% to 4.9%)			
As Built Desc:	4.5% cross slope			
Solution:	Demolish existing and construct new route			
Bar. Severity:	2 Recommended	Cost Estimate:	\$28,875.00	Status:
Implementation Priority:	4	Facility Function:		
Implementation Phase:		Implementation Date:		
Official Responsible:				
Notes:

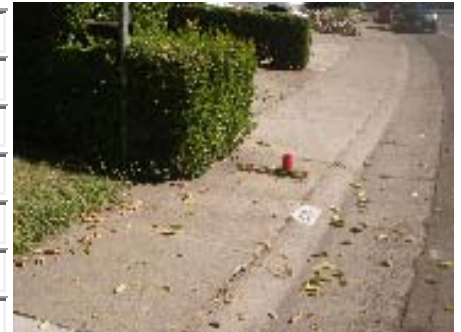
Field Date:	#####	Report Date:	10/15/2010	Barrier #:	810
Location:	Tupelo Dr - North				
X Coordinate:	-121.32152				
Y Coordinate:	38.69901				
Barrier Area:	Sidewalks				
Barrier Type:	Clear Width - Existing ($\leq 31"$ or less)				
Code Ref:	CBC 1133B.7.1

As Built Meas:	1	Quantity:	LF
Description:	Pedestrian route is not min. 48" wide ($\leq 31"$ or less)		
As Built Desc:	30" clear width due to foliage		
Solution:	Trim foliage to provide min. 48" clear width		
Bar. Severity:	1 Necessary	Cost Estimate:	\$125.00
Implementation Priority:	4	Facility Function:	
Implementation Phase:		Implementation Date:	
Official Responsible:

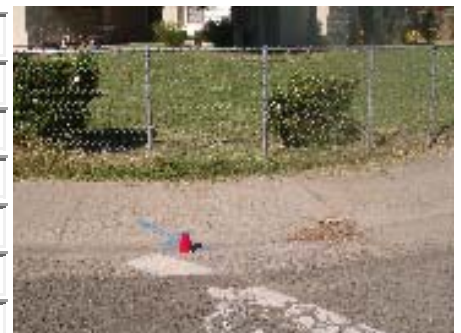
Field Date:	#####	Report Date:	10/15/2010	Barrier #:	811
Location:	Tupelo Dr and Parkvale Wy - Corner A				
X Coordinate:	-121.32081				
Y Coordinate:	38.69918				
Barrier Area:	Curb Ramps				
Barrier Type:	No Curb Ramp - Depressed Existing Curb				
Code Ref:	CBC 1127B.5.1 and ADA/ABA 402.2

As Built Meas:	1	Quantity:	EACH
Description:	No compliant curb cut at corner (intersection)		
As Built Desc:	13.7% running slope at depressed area		
Solution:	Demolish existing and construct curb cut		
Bar. Severity:	1 Necessary	Cost Estimate:	\$2,500.00
Implementation Priority:	4	Facility Function:	
Implementation Phase:		Implementation Date:	
Official Responsible:

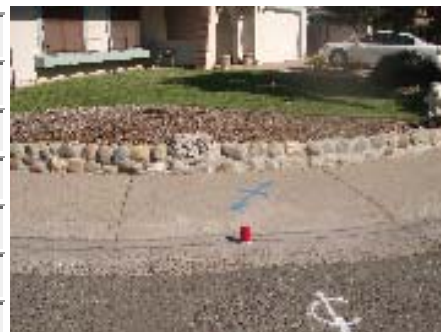
Barrier Type: No Curb Ramp - Depressed Exsiting Curb

Description: No compliant curb cut at corner (intersection)

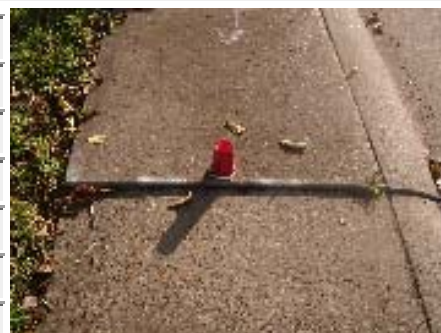
Barrier Type: Abrupt Change in Level - > 1/2"

Description: Change in level greater than 1/2"

Solution: Grind or repair sidewalk to remove trip hazard

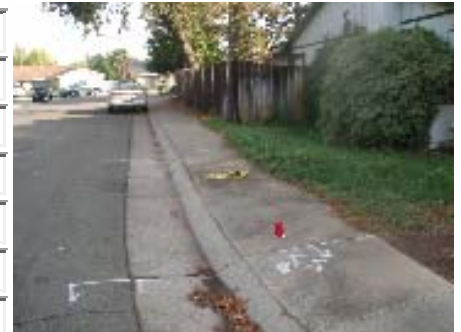
Field Date:	#####	Report Date:	10/18/2010	Barrier #:	820
Location:	Springvale Wy - East				
X Coordinate:	-121.32238				
Y Coordinate:	38.69964				
Barrier Area:	Sidewalks				
Barrier Type:	Cross Slope - Existing (5.0% or more)				
Code Ref:	CBC 1133B.7.1.3 and ADA/ABA 403.3

As Built Meas:	175	Quantity:	LF
Description:	Cross slope exceeds 2.0% (5.0% or more)		
As Built Desc:	5.7% cross slope		
Solution:	Demolish existing and construct new route		
Bar. Severity:	1 Necessary	Cost Estimate:	\$21,875.00
Implementation Priority:	4	Facility Function:	
Implementation Phase:		Implementation Date:	
Official Responsible:			
Notes:

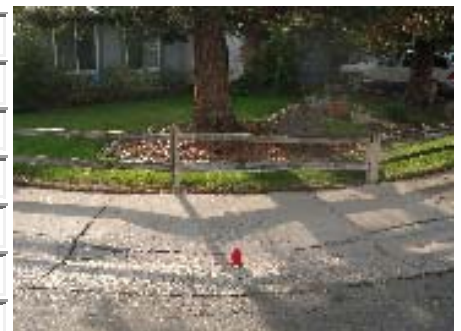
Field Date:	#####	Report Date:	10/18/2010	Barrier #:	821
Location:	Springvale Wy - East				
X Coordinate:	-121.32236				
Y Coordinate:	38.70019				
Barrier Area:	Sidewalks				
Barrier Type:	Elbow in Sidewalk - Cross Slope (5.0% or more)				
Code Ref:	CBC 1133B.7.1.3 and ADA/ABA 403.3

As Built Meas:	6	Quantity:	LF
Description:	Cross slope at elbow exceeds 2.0% (5.0% or more)		
As Built Desc:	13.7% cross slope		
Solution:	Demolish existing and construct new sidewalk without curb ramp		
Bar. Severity:	1 Necessary	Cost Estimate:	\$750.00
Implementation Priority:	4	Facility Function:	
Implementation Phase:		Implementation Date:	
Official Responsible:			
Notes:

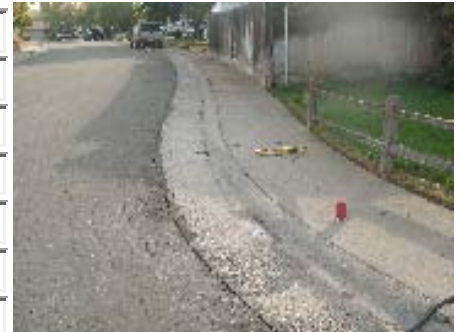
Field Date:	#####	Report Date:	10/18/2010	Barrier #:	822
Location:	Springvale Wy - South				
X Coordinate:	-121.32226				
Y Coordinate:	38.70021				
Barrier Area:	Sidewalks				
Barrier Type:	Cross Slope - Existing (5.0% or more)				
Code Ref:	CBC 1133B.7.1.3 and ADA/ABA 403.3

As Built Meas:	451	Quantity:	LF
Description:	Cross slope exceeds 2.0% (5.0% or more)		
As Built Desc:	6.3% cross slope		
Solution:	Demolish existing and construct new route		
Bar. Severity:	1 Necessary	Cost Estimate:	\$56,375.00
Implementation Priority:	4	Facility Function:	
Implementation Phase:		Implementation Date:	
Official Responsible:			
Notes:

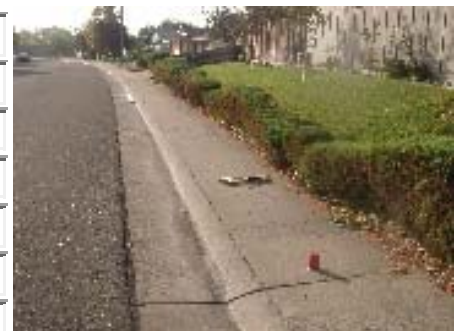
Field Date:	#####	Report Date:	10/18/2010	Barrier #:	823
Location:	Blackthorne Wy - West				
X Coordinate:	-121.32074				
Y Coordinate:	38.70051				
Barrier Area:	Sidewalks				
Barrier Type:	Cross Slope - Existing (5.0% or more)				
Code Ref:	CBC 1133B.7.1.3 and ADA/ABA 403.3

As Built Meas:	514	Quantity:	LF
Description:	Cross slope exceeds 2.0% (5.0% or more)		
As Built Desc:	5.0% cross slope		
Solution:	Demolish existing and construct new route		
Bar. Severity:	1 Necessary	Cost Estimate:	\$64,250.00
Implementation Priority:	4	Facility Function:	
Implementation Phase:		Implementation Date:	
Official Responsible:			
Notes:

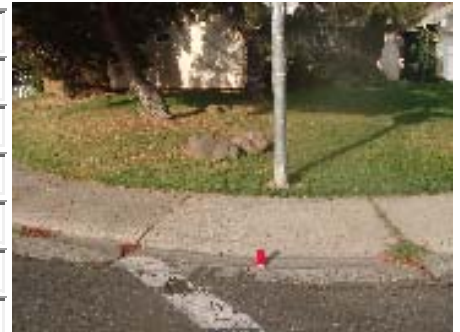
Field Date:	#####	Report Date:	10/18/2010	Barrier #:	824
Location:	Blackthorne Wy and Tupelo Dr - Corner A				
X Coordinate:	-121.31975				
Y Coordinate:	38.69936				
Barrier Area:	Curb Ramps				
Barrier Type:	No Curb Ramp - Depressed Exsiting Curb				
Code Ref:	CBC 1127B.5.1 and ADA/ABA 402.2

As Built Meas:	1	Quantity:	EACH		
Description:	No compliant curb cut at corner (intersection)				
As Built Desc:	12.5% running slope at depressed area				
Solution:	Demolish existing and construct curb cut				
Bar. Severity:	1 Necessary	Cost Estimate:	\$2,500.00	Status:	
Implementation Priority:	4	Facility Function:			
Implementation Phase:		Implementation Date:			
Official Responsible:					
Notes:	Two - way intersection corners A,B

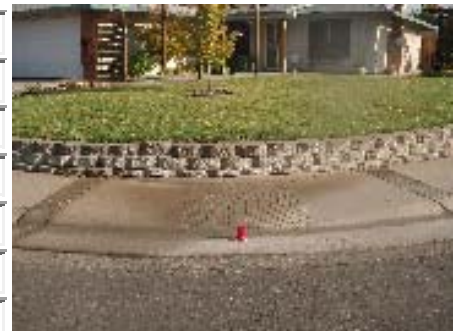
Field Date:	#####	Report Date:	10/18/2010	Barrier #:	825A
Location:	Blackthorne Wy and Tupelo Dr - Corner B				
X Coordinate:	-121.31962				
Y Coordinate:	38.69944				
Barrier Area:	Curb Ramps				
Barrier Type:	Parallel Ramp Landing - New Construction				
Code Ref:	CBC 1127B.5.9 and ADA/ABA 406.4

As Built Meas:	1	Quantity:	EACH		
Description:	Curb ramp pan is not level (2.0% in all directions)				
As Built Desc:	3.1% landing slope				
Solution:	Demolish existing and construct new curb ramp				
Bar. Severity:	1 Necessary	Cost Estimate:	\$2,500.00	Status:	
Implementation Priority:	4	Facility Function:			
Implementation Phase:		Implementation Date:			
Official Responsible:					
Notes:	Two - way intersection corners A,B

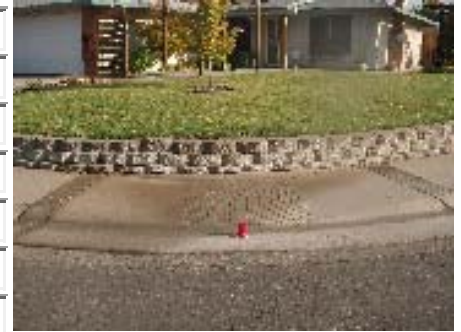
Barrier Type: Detectable Warnings - Truncated Domes

Description: No truncated domes provided at curb ramp

Bar. Severity: 2 Recommended

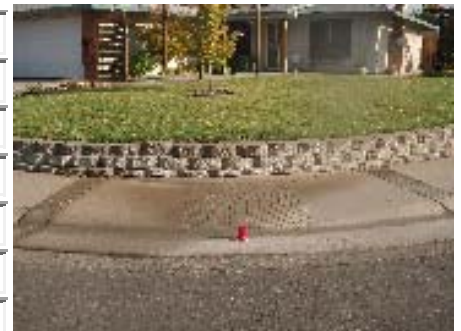
Barrier Type: Gutter Slope - Existing (5.9% - 6.5%)

Description: Gutter slope exceeds 5.0% (5.9% - 6.5%)

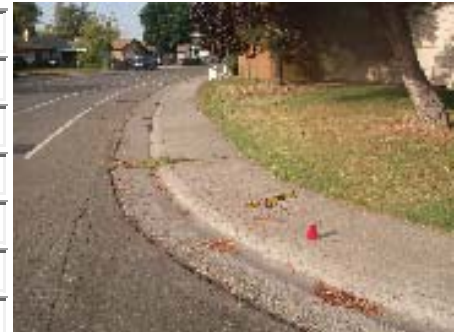
Field Date:	#####	Report Date:	10/18/2010	Barrier #:	826A
Location:	Tupelo Dr - North				
X Coordinate:	-121.31966				
Y Coordinate:	38.69939				
Barrier Area:	Sidewalks				
Barrier Type:	Cross Slope - Existing (5.0% or more)				
Code Ref:	CBC 1133B.7.1.3 and ADA/ABA 403.3

As Built Meas:	264	Quantity:	LF		
Description:	Cross slope exceeds 2.0% (5.0% or more)				
As Built Desc:	6.6% cross slope				
Solution:	Demolish existing and construct new route				
Bar. Severity:	1 Necessary	Cost Estimate:	\$33,000.00	Status:	
Implementation Priority:	4	Facility Function:			
Implementation Phase:		Implementation Date:			
Official Responsible:					
Notes:

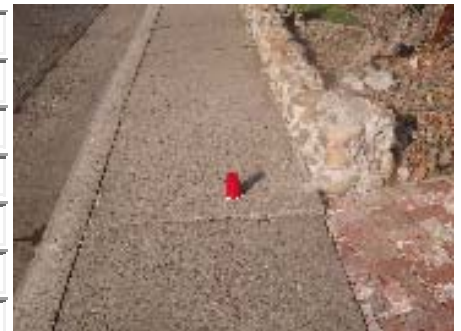
Field Date:	#####	Report Date:	10/18/2010	Barrier #:	826B
Location:	Tupelo Dr - North				
X Coordinate:	-121.3204				
Y Coordinate:	38.69922				
Barrier Area:	Sidewalks				
Barrier Type:	Abrupt Change in Level - > 1/2"				
Code Ref:	CBC 1133B.7.1 and ADA/ABA 303.3

As Built Meas:	4	Quantity:	LF		
Description:	Change in level greater than 1/2"				
As Built Desc:	1/2" lip in sidewalk surface				
Solution:	Grind or repair sidewalk to remove trip hazard				
Bar. Severity:	1 Necessary	Cost Estimate:	\$1,000.00	Status:	
Implementation Priority:	4	Facility Function:			
Implementation Phase:		Implementation Date:			
Official Responsible:					
Notes:

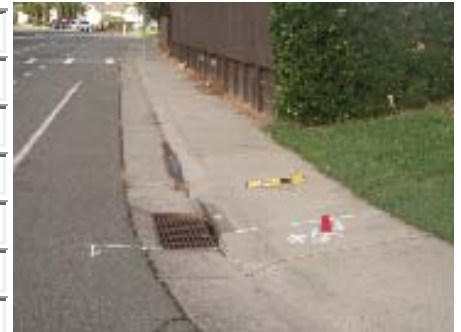
Field Date:	#####	Report Date:	10/18/2010	Barrier #:	827
Location:	Tupelo Dr - North				
X Coordinate:	-121.3236				
Y Coordinate:	38.69898				
Barrier Area:	Sidewalks				
Barrier Type:	Cross Slope - Existing (5.0% or more)				
Code Ref:	CBC 1133B.7.1.3 and ADA/ABA 403.3

As Built Meas:	180	Quantity:	LF
Description:	Cross slope exceeds 2.0% (5.0% or more)		
As Built Desc:	5.6% cross slope		
Solution:	Demolish existing and construct new route		
Bar. Severity:	1 Necessary	Cost Estimate:	\$22,500.00
Implementation Priority:	4	Facility Function:	
Implementation Phase:		Implementation Date:	
Official Responsible:			
Notes:

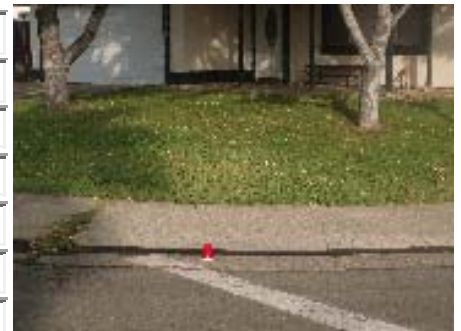
Field Date:	#####	Report Date:	10/18/2010	Barrier #:	828
Location:	Tupelo Dr and Windjammer Wy - Corner A				
X Coordinate:	-121.32436				
Y Coordinate:	38.69898				
Barrier Area:	Curb Ramps				
Barrier Type:	No Curb Ramp - Depressed Existing Curb				
Code Ref:	CBC 1127B.5.1 and ADA/ABA 402.2

As Built Meas:	1	Quantity:	EACH
Description:	No compliant curb cut at corner (intersection)		
As Built Desc:	6.5% running slope at depressed area		
Solution:	Demolish existing and construct curb cut		
Bar. Severity:	1 Necessary	Cost Estimate:	\$2,500.00
Implementation Priority:	4	Facility Function:	
Implementation Phase:		Implementation Date:	
Official Responsible:			
Notes:	Four - way intersection corners A,B,C,D

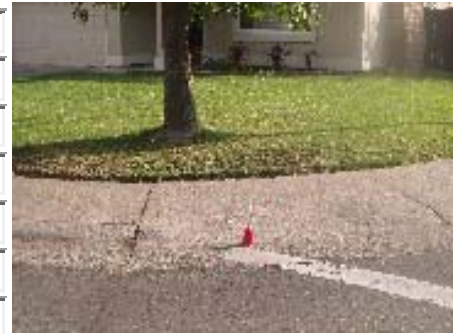
Field Date:	#####	Report Date:	10/18/2010	Barrier #:	829
Location:	Tupelo Dr and Windjammer Wy - Corner B				
X Coordinate:	-121.32427				
Y Coordinate:	38.69894				
Barrier Area:	Curb Ramps				
Barrier Type:	No Curb Ramp - Depressed Exsiting Curb				
Code Ref:	CBC 1127B.5.1 and ADA/ABA 402.2

As Built Meas:	1	Quantity:	EACH		
Description:	No compliant curb cut at corner (intersection)				
As Built Desc:	9.8% running slope at depressed area				
Solution:	Demolish existing and construct curb cut				
Bar. Severity:	1 Necessary	Cost Estimate:	\$2,500.00	Status:	
Implementation Priority:	4	Facility Function:			
Implementation Phase:		Implementation Date:			
Official Responsible:					
Notes:	Four - way intersection corners A,B,C,D
