DRAFT ADA TRANSITION PLAN UPDATE
NEIGHBORHOOD AREA 1 NORTHWEST
SEPTEMBER 20, 2011

CITY OF CITRUS HEIGHTS

The Northwest Neighborhood Association

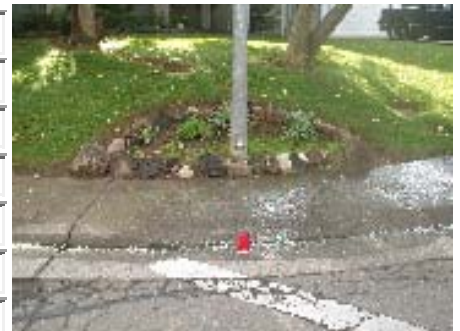
Field Date:	#####	Report Date:	10/18/2010	Barrier #:	830
Location:	Tupelo Dr and Windjammer Wy - Corner C				
X Coordinate:	-121.32422				
Y Coordinate:	38.6988				
Barrier Area:	Curb Ramps				
Barrier Type:	No Curb Ramp - Depressed Exsiting Curb				
Code Ref:	CBC 1127B.5.1 and ADA/ABA 402.2

As Built Meas:	1	Quantity:	EACH		
Description:	No compliant curb cut at corner (intersection)				
As Built Desc:	9.7% running slope at depressed area				
Solution:	Demolish existing and construct curb cut				
Bar. Severity:	1 Necessary	Cost Estimate:	\$2,500.00	Status:	
Implementation Priority:	4	Facility Function:			
Implementation Phase:		Implementation Date:			
Official Responsible:					
Notes:	Four - way intersection corners A,B,C,D

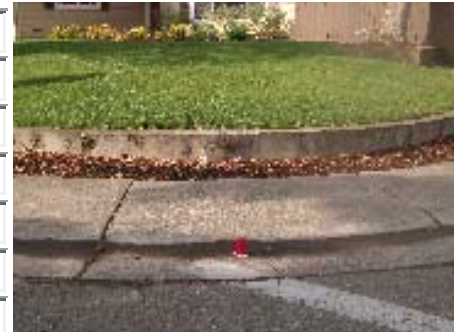
Field Date:	#####	Report Date:	10/18/2010	Barrier #:	831
Location:	Tupelo Dr and Windjammer Wy - Corner D				
X Coordinate:	-121.32437				
Y Coordinate:	38.69884				
Barrier Area:	Curb Ramps				
Barrier Type:	No Curb Ramp - Depressed Exsiting Curb				
Code Ref:	CBC 1127B.5.1 and ADA/ABA 402.2

As Built Meas:	1	Quantity:	EACH
Description:	No compliant curb cut at corner (intersection)		
As Built Desc:	9.5% running slope at depressed area		
Solution:	Demolish existing and construct curb cut		
Bar. Severity:	1 Necessary	Cost Estimate:	\$2,500.00
Implementation Priority:	4	Facility Function:	
Implementation Phase:		Implementation Date:	
Official Responsible:			
Notes:	Four - way intersection corners A,B,C,D

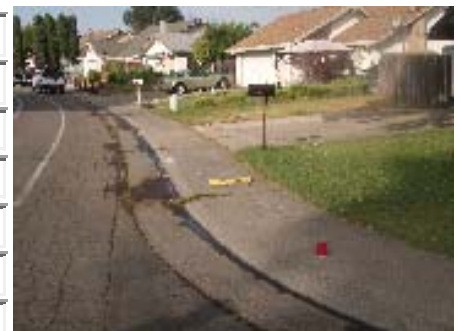
Field Date:	#####	Report Date:	10/18/2010	Barrier #:	832
Location:	Tupelo Dr - North				
X Coordinate:	-121.32445				
Y Coordinate:	38.69896				
Barrier Area:	Sidewalks				
Barrier Type:	Cross Slope - Existing (4.1% to 4.9%)				
Code Ref:	CBC 1133B.7.1.3 and ADA/ABA 403.3

As Built Meas:	589	Quantity:	LF
Description:	Cross slope exceeds 2.0% (4.1% to 4.9%)		
As Built Desc:	4.8% cross slope		
Solution:	Demolish existing and construct new route		
Bar. Severity:	2 Recommended	Cost Estimate:	\$73,625.00
Implementation Priority:	4	Facility Function:	
Implementation Phase:		Implementation Date:	
Official Responsible:			
Notes:

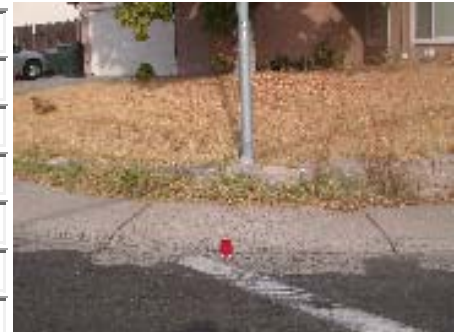
Field Date:	#####	Report Date:	10/18/2010	Barrier #:	833
Location:	Tupelo Dr and Daly Ave - Corner A				
X Coordinate:	-121.32664				
Y Coordinate:	38.69851				
Barrier Area:	Curb Ramps				
Barrier Type:	No Curb Ramp - Depressed Exsiting Curb				
Code Ref:	CBC 1127B.5.1 and ADA/ABA 402.2

As Built Meas:	1	Quantity:	EACH		
Description:	No compliant curb cut at corner (intersection)				
As Built Desc:	9.6% running slope at depressed area				
Solution:	Demolish existing and construct curb cut				
Bar. Severity:	1 Necessary	Cost Estimate:	\$2,500.00	Status:	
Implementation Priority:	4	Facility Function:			
Implementation Phase:		Implementation Date:			
Official Responsible:					
Notes:	Two - way intersection corners A,B

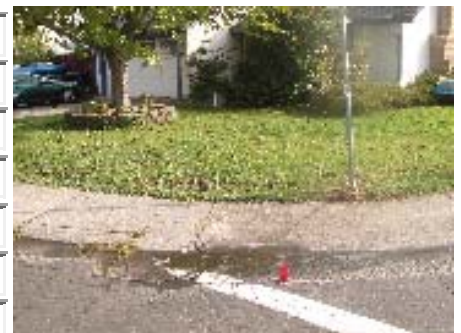
Field Date:	#####	Report Date:	10/18/2010	Barrier #:	834
Location:	Tupelo Dr and Daly Ave - Corner B				
X Coordinate:	-121.32639				
Y Coordinate:	38.69858				
Barrier Area:	Curb Ramps				
Barrier Type:	No Curb Ramp - Depressed Exsiting Curb				
Code Ref:	CBC 1127B.5.1 and ADA/ABA 402.2

As Built Meas:	1	Quantity:	EACH		
Description:	No compliant curb cut at corner (intersection)				
As Built Desc:	8.8% running slope at depressed area				
Solution:	Demolish existing and construct curb cut				
Bar. Severity:	1 Necessary	Cost Estimate:	\$2,500.00	Status:	
Implementation Priority:	4	Facility Function:			
Implementation Phase:		Implementation Date:			
Official Responsible:					
Notes:	Two - way intersection corners A,B

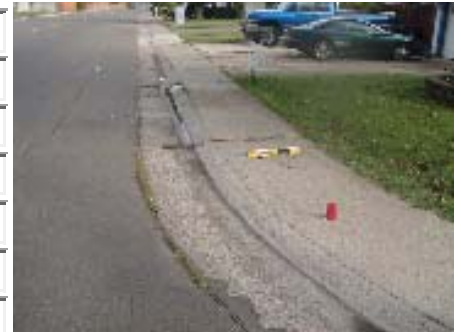
Field Date:	#####	Report Date:	10/18/2010	Barrier #:	835
Location:	Daly Ave - East				
X Coordinate:	-121.32643				
Y Coordinate:	38.69856				
Barrier Area:	Sidewalks				
Barrier Type:	Cross Slope - Existing (5.0% or more)				
Code Ref:	CBC 1133B.7.1.3 and ADA/ABA 403.3

As Built Meas:	596	Quantity:	LF
Description:	Cross slope exceeds 2.0% (5.0% or more)		
As Built Desc:	5.4% cross slope		
Solution:	Demolish existing and construct new route		
Bar. Severity:	1 Necessary	Cost Estimate:	\$74,500.00
Implementation Priority:	4	Facility Function:	
Implementation Phase:		Implementation Date:	
Official Responsible:

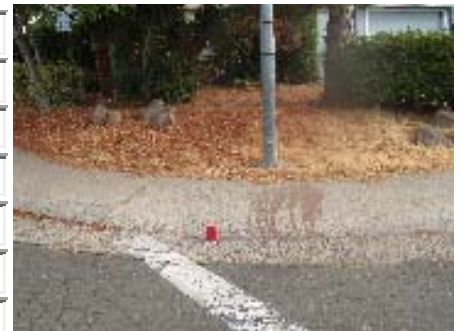
Field Date:	#####	Report Date:	10/18/2010	Barrier #:	836
Location:	Daly Ave and Trawler Wy - Corner B				
X Coordinate:	-121.3263				
Y Coordinate:	38.70033				
Barrier Area:	Curb Ramps				
Barrier Type:	No Curb Ramp - Depressed Existing Curb				
Code Ref:	CBC 1127B.5.1 and ADA/ABA 402.2

As Built Meas:	1	Quantity:	EACH
Description:	No compliant curb cut at corner (intersection)		
As Built Desc:	7.5% running slope at depressed area		
Solution:	Demolish existing and construct curb cut		
Bar. Severity:	1 Necessary	Cost Estimate:	\$2,500.00
Implementation Priority:	4	Facility Function:	
Implementation Phase:		Implementation Date:	
Official Responsible:

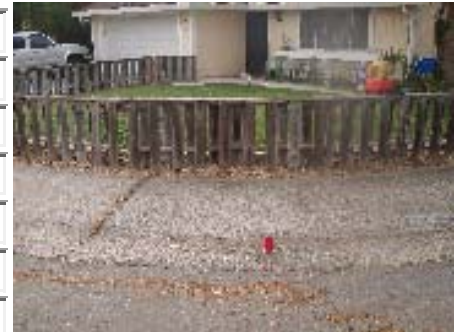
Field Date:	#####	Report Date:	10/18/2010	Barrier #:	837
Location:	Daly Ave and Trawler Wy - Corner C				
X Coordinate:	-121.32626				
Y Coordinate:	38.70023				
Barrier Area:	Curb Ramps				
Barrier Type:	No Curb Ramp - Depressed Exsiting Curb				
Code Ref:	CBC 1127B.5.1 and ADA/ABA 402.2

As Built Meas:	1	Quantity:	EACH
Description:	No compliant curb cut at corner (intersection)		
As Built Desc:	7.7% running slope at depressed area		
Solution:	Demolish existing and construct curb cut		
Bar. Severity:	1 Necessary	Cost Estimate:	\$2,500.00
Implementation Priority:	4	Facility Function:	
Implementation Phase:		Implementation Date:	
Official Responsible:			
Notes:	Two - way intersection corners B,C

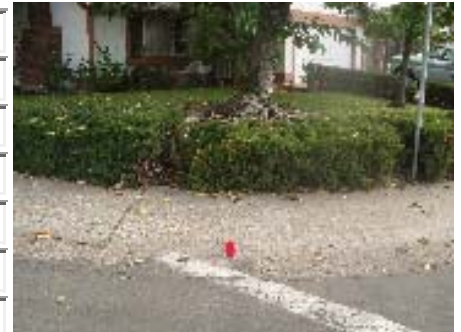
Field Date:	#####	Report Date:	10/18/2010	Barrier #:	839
Location:	Daly Ave and Windjammer Wy - Corner B				
X Coordinate:	-121.32625				
Y Coordinate:	38.70098				
Barrier Area:	Curb Ramps				
Barrier Type:	No Curb Ramp - Depressed Exsiting Curb				
Code Ref:	CBC 1127B.5.1 and ADA/ABA 402.2

As Built Meas:	1	Quantity:	EACH
Description:	No compliant curb cut at corner (intersection)		
As Built Desc:	7.7% running slope at depressed area		
Solution:	Demolish existing and construct curb cut		
Bar. Severity:	1 Necessary	Cost Estimate:	\$2,500.00
Implementation Priority:	4	Facility Function:	
Implementation Phase:		Implementation Date:	
Official Responsible:			
Notes:	Two - way intersection corners B,C

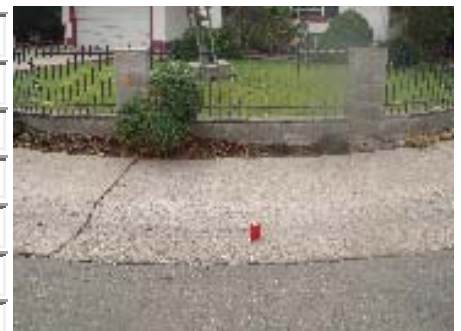
Field Date:	#####	Report Date:	10/18/2010	Barrier #:	840
Location:	Daly Ave and Windjammer Wy - Corner C				
X Coordinate:	-121.32626				
Y Coordinate:	38.70089				
Barrier Area:	Curb Ramps				
Barrier Type:	No Curb Ramp - Depressed Exsiting Curb				
Code Ref:	CBC 1127B.5.1 and ADA/ABA 402.2

As Built Meas:	1	Quantity:	EACH
Description:	No compliant curb cut at corner (intersection)		
As Built Desc:	10.9% running slope at depressed area		
Solution:	Demolish existing and construct curb cut		
Bar. Severity:	1 Necessary	Cost Estimate:	\$2,500.00
Implementation Priority:	4	Facility Function:	
Implementation Phase:		Implementation Date:	
Official Responsible:			
Notes:	Two - way intersection corners B,C

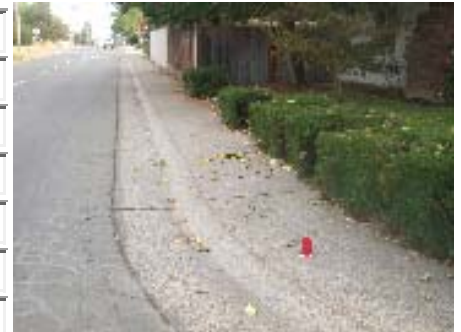
Field Date:	#####	Report Date:	10/18/2010	Barrier #:	841
Location:	Daly Ave - East				
X Coordinate:	-121.32627				
Y Coordinate:	38.70107				
Barrier Area:	Sidewalks				
Barrier Type:	Cross Slope - Existing (5.0% or more)				
Code Ref:	CBC 1133B.7.1.3 and ADA/ABA 403.3

As Built Meas:	189	Quantity:	LF	
Description:	Cross slope exceeds 2.0% (5.0% or more)			
As Built Desc:	5.1% cross slope			
Solution:	Demolish existing and construct new route			
Bar. Severity:	1 Necessary	Cost Estimate:	\$23,625.00	Status:
Implementation Priority:	4	Facility Function:		
Implementation Phase:		Implementation Date:		
Official Responsible:				
Notes:

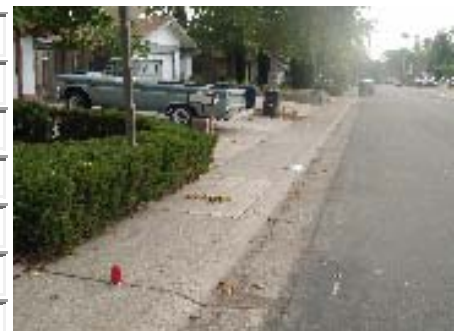
Field Date:	#####	Report Date:	10/18/2010	Barrier #:	842
Location:	Windjammer Wy - North				
X Coordinate:	-121.32623				
Y Coordinate:	38.70095				
Barrier Area:	Sidewalks				
Barrier Type:	Cross Slope - Existing (4.1% to 4.9%)				
Code Ref:	CBC 1133B.7.1.3 and ADA/ABA 403.3

As Built Meas:	554	Quantity:	LF	
Description:	Cross slope exceeds 2.0% (4.1% to 4.9%)			
As Built Desc:	4.6% cross slope			
Solution:	Demolish existing and construct new route			
Bar. Severity:	2 Recommended	Cost Estimate:	\$69,250.00	Status:
Implementation Priority:	4	Facility Function:		
Implementation Phase:		Implementation Date:		
Official Responsible:				
Notes:

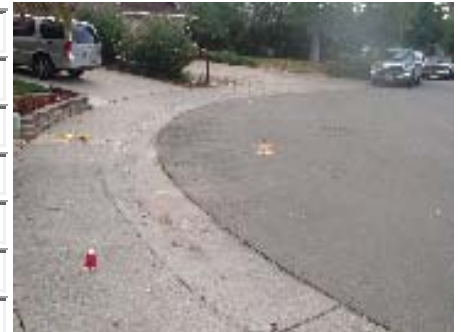
Field Date:	#####	Report Date:	10/18/2010	Barrier #:	843A
Location:	Windjammer Wy - East				
X Coordinate:	-121.32428				
Y Coordinate:	38.70099				
Barrier Area:	Sidewalks				
Barrier Type:	Cross Slope - Existing (5.0% or more)				
Code Ref:	CBC 1133B.7.1.3 and ADA/ABA 403.3

As Built Meas:	210	Quantity:	LF	
Description:	Cross slope exceeds 2.0% (5.0% or more)			
As Built Desc:	8.0% cross slope			
Solution:	Demolish existing and construct new route			
Bar. Severity:	1 Necessary	Cost Estimate:	\$26,250.00	Status:
Implementation Priority:	4	Facility Function:		
Implementation Phase:		Implementation Date:		
Official Responsible:				
Notes:

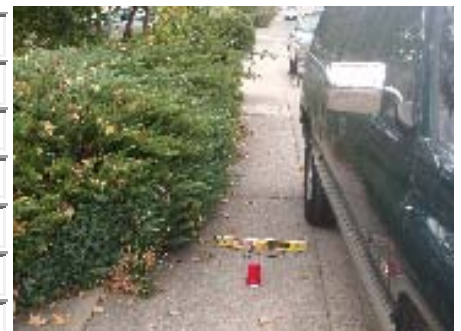
Field Date:	#####	Report Date:	10/18/2010	Barrier #:	843B
Location:	Windjammer Wy - East				
X Coordinate:	-121.32421				
Y Coordinate:	38.70082				
Barrier Area:	Sidewalks				
Barrier Type:	Clear Width - New Construction				
Code Ref:	CBC 1133B.7.1

As Built Meas:	1	Quantity:	LF	
Description:	Pedestrian route is not min. 48" wide			
As Built Desc:	24" clear width due to foliage			
Solution:	Trim foliage to provide min. 48" clear width			
Bar. Severity:	1 Necessary	Cost Estimate:	\$125.00	Status:
Implementation Priority:	4	Facility Function:		
Implementation Phase:		Implementation Date:		
Official Responsible:				
Notes:

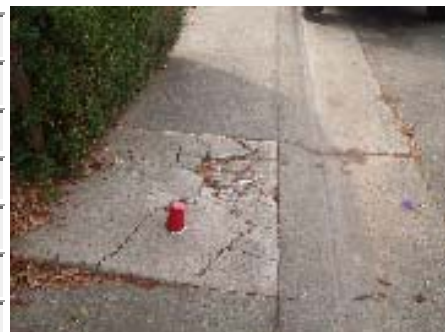
Barrier Type: Surface Condition - Damaged

Description: Surface is not firm and stable (cracked, broken or loose soil, etc.)

As Built Desc: Cracked concrete

Solution: Repair surface to make firm and stable

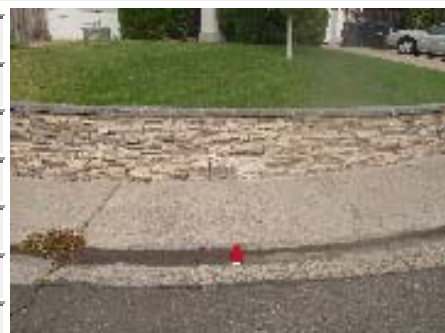
Barrier Type: No Curb Ramp - Depressed Existing Curb

Description: No compliant curb cut at corner (intersection)

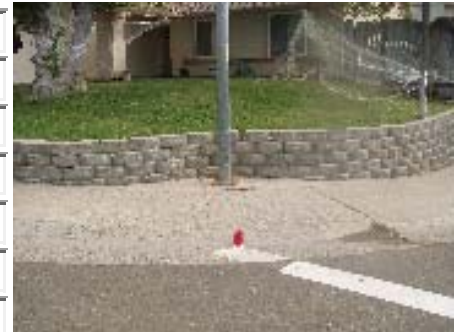
Field Date:	#####	Report Date:	10/18/2010	Barrier #:	845
Location:	Windjammer Wy and Windlass Ct - Corner B				
X Coordinate:	-121.32419				
Y Coordinate:	38.70038				
Barrier Area:	Curb Ramps				
Barrier Type:	No Curb Ramp - Depressed Exsiting Curb				
Code Ref:	CBC 1127B.5.1 and ADA/ABA 402.2

As Built Meas:	1	Quantity:	EACH
Description:	No compliant curb cut at corner (intersection)		
As Built Desc:	6.2% running slope at depressed area		
Solution:	Demolish existing and construct curb cut		
Bar. Severity:	1 Necessary	Cost Estimate:	\$2,500.00
Implementation Priority:	4	Facility Function:	
Implementation Phase:		Implementation Date:	
Official Responsible:			
Notes:	Four - way intersection corners A,B,C,D

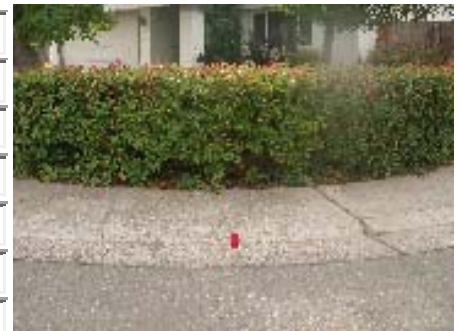
Field Date:	#####	Report Date:	10/18/2010	Barrier #:	846
Location:	Windjammer Wy and Windlass Ct - Corner C				
X Coordinate:	-121.32419				
Y Coordinate:	38.70027				
Barrier Area:	Curb Ramps				
Barrier Type:	No Curb Ramp - Depressed Exsiting Curb				
Code Ref:	CBC 1127B.5.1 and ADA/ABA 402.2

As Built Meas:	1	Quantity:	EACH
Description:	No compliant curb cut at corner (intersection)		
As Built Desc:	9.3% running slope at depressed area		
Solution:	Demolish existing and construct curb cut		
Bar. Severity:	1 Necessary	Cost Estimate:	\$2,500.00
Implementation Priority:	4	Facility Function:	
Implementation Phase:		Implementation Date:	
Official Responsible:			
Notes:	Four - way intersection corners A,B,C,D

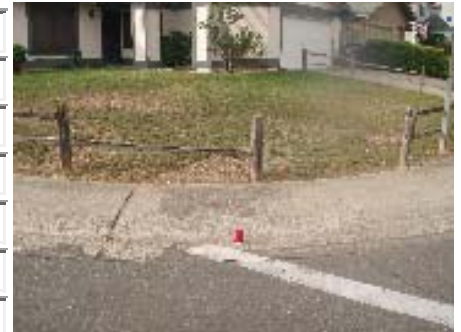
Field Date:	#####	Report Date:	10/18/2010	Barrier #:	847
Location:	Windjammer Wy and Windlass Ct - Corner D				
X Coordinate:	-121.32433				
Y Coordinate:	38.70026				
Barrier Area:	Curb Ramps				
Barrier Type:	No Curb Ramp - Depressed Exsiting Curb				
Code Ref:	CBC 1127B.5.1 and ADA/ABA 402.2

As Built Meas:	1	Quantity:	EACH
Description:	No compliant curb cut at corner (intersection)		
As Built Desc:	8.1% running slope at depressed area		
Solution:	Demolish existing and construct curb cut		
Bar. Severity:	1 Necessary	Cost Estimate:	\$2,500.00
Implementation Priority:	4	Facility Function:	
Implementation Phase:		Implementation Date:	
Official Responsible:			
Notes:	Four - way intersection corners A,B,C,D

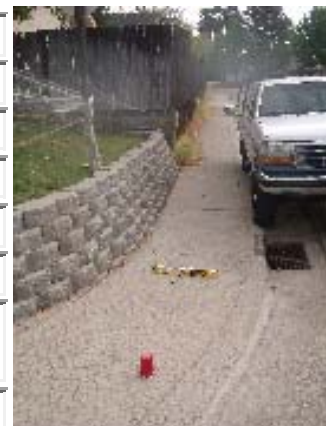
Field Date:	#####	Report Date:	10/18/2010	Barrier #:	848
Location:	Windlass Ct - North				
X Coordinate:	-121.32415				
Y Coordinate:	38.70035				
Barrier Area:	Sidewalks				
Barrier Type:	Cross Slope - Existing (5.0% or more)				
Code Ref:	CBC 1133B.7.1.3 and ADA/ABA 403.3

As Built Meas:	226	Quantity:	LF
Description:	Cross slope exceeds 2.0% (5.0% or more)		
As Built Desc:	5.4% cross slope		
Solution:	Demolish existing and construct new route		
Bar. Severity:	1 Necessary	Cost Estimate:	\$28,250.00
Implementation Priority:	4	Facility Function:	
Implementation Phase:		Implementation Date:	
Official Responsible:			
Notes:

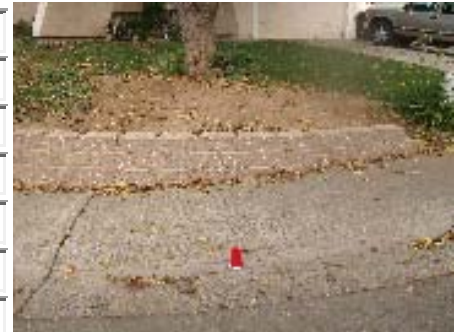
Field Date:	#####	Report Date:	10/18/2010	Barrier #:	849
Location:	Windlass Ct - North				
X Coordinate:	-121.3234				
Y Coordinate:	38.7004				
Barrier Area:	Sidewalks				
Barrier Type:	Elbow in Sidewalk - Cross Slope (5.0% or more)				
Code Ref:	CBC 1133B.7.1.3 and ADA/ABA 403.3

As Built Meas:	10	Quantity:	LF
Description:	Cross slope at elbow exceeds 2.0% (5.0% or more)		
As Built Desc:	8.0% cross slope		
Solution:	Demolish existing and construct new sidewalk without curb ramp		
Bar. Severity:	1 Necessary	Cost Estimate:	\$1,250.00
Implementation Priority:	4	Facility Function:	
Implementation Phase:		Implementation Date:	
Official Responsible:			
Notes:

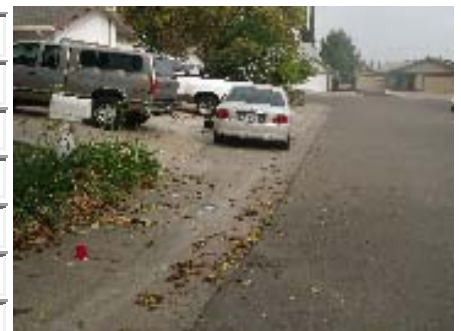
Field Date:	#####	Report Date:	10/18/2010	Barrier #:	850
Location:	Windlass Ct - West				
X Coordinate:	-121.32339				
Y Coordinate:	38.70044				
Barrier Area:	Sidewalks				
Barrier Type:	Cross Slope - Existing (4.1% to 4.9%)				
Code Ref:	CBC 1133B.7.1.3 and ADA/ABA 403.3

As Built Meas:	259	Quantity:	LF
Description:	Cross slope exceeds 2.0% (4.1% to 4.9%)		
As Built Desc:	4.7% cross slope		
Solution:	Demolish existing and construct new route		
Bar. Severity:	2 Recommended	Cost Estimate:	\$32,375.00
Implementation Priority:	4	Facility Function:	
Implementation Phase:		Implementation Date:	
Official Responsible:			
Notes:

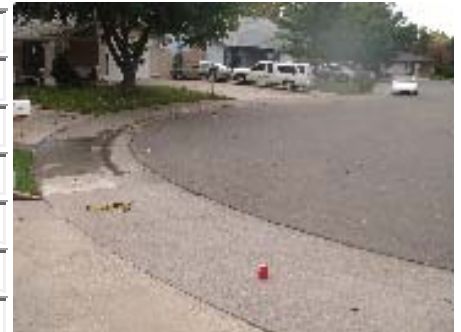
Field Date:	#####	Report Date:	10/18/2010	Barrier #:	851
Location:	Windless Ct - East				
X Coordinate:	-121.32331				
Y Coordinate:	38.70101				
Barrier Area:	Sidewalks				
Barrier Type:	Cross Slope - Existing (4.1% to 4.9%)				
Code Ref:	CBC 1133B.7.1.3 and ADA/ABA 403.3

As Built Meas:	529	Quantity:	LF
Description:	Cross slope exceeds 2.0% (4.1% to 4.9%)		
As Built Desc:	4.4% cross slope		
Solution:	Demolish existing and construct new route		
Bar. Severity:	2 Recommended	Cost Estimate:	\$66,125.00
Implementation Priority:	4	Facility Function:	
Implementation Phase:		Implementation Date:	
Official Responsible:			
Notes:

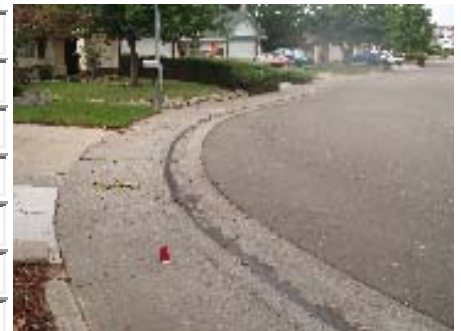
Field Date:	#####	Report Date:	10/18/2010	Barrier #:	852
Location:	Windless Ct - East				
X Coordinate:	-121.32334				
Y Coordinate:	38.70031				
Barrier Area:	Sidewalks				
Barrier Type:	Elbow in Sidewalk - Cross Slope (5.0% or more)				
Code Ref:	CBC 1133B.7.1.3 and ADA/ABA 403.3

As Built Meas:	10	Quantity:	LF
Description:	Cross slope at elbow exceeds 2.0% (5.0% or more)		
As Built Desc:	9.2% cross slope		
Solution:	Demolish existing and construct new sidewalk without curb ramp		
Bar. Severity:	1 Necessary	Cost Estimate:	\$1,250.00
Implementation Priority:	4	Facility Function:	
Implementation Phase:		Implementation Date:	
Official Responsible:			
Notes:

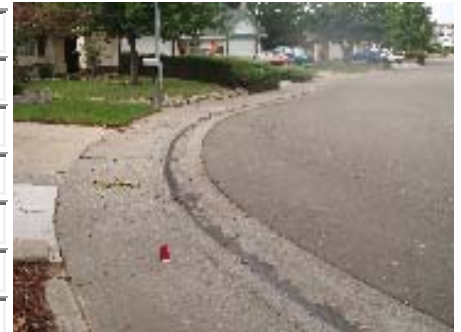
Field Date:	#####	Report Date:	10/18/2010	Barrier #:	853
Location:	Windless Ct - South				
X Coordinate:	-121.32334				
Y Coordinate:	38.70031				
Barrier Area:	Sidewalks				
Barrier Type:	Cross Slope - Existing (4.1% to 4.9%)				
Code Ref:	CBC 1133B.7.1.3 and ADA/ABA 403.3

As Built Meas:	245	Quantity:	LF
Description:	Cross slope exceeds 2.0% (4.1% to 4.9%)		
As Built Desc:	4.1% cross slope		
Solution:	Demolish existing and construct new route		
Bar. Severity:	2 Recommended	Cost Estimate:	\$30,625.00
Implementation Priority:	4	Facility Function:	
Implementation Phase:		Implementation Date:	
Official Responsible:

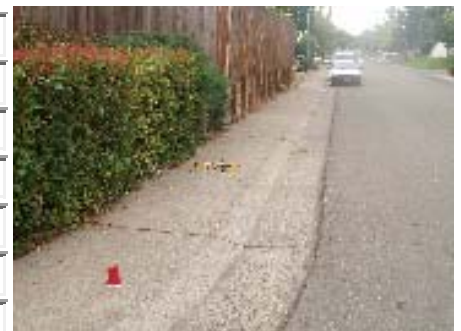
Field Date:	#####	Report Date:	10/18/2010	Barrier #:	854
Location:	Windjammer Wy - East				
X Coordinate:	-121.32422				
Y Coordinate:	38.70022				
Barrier Area:	Sidewalks				
Barrier Type:	Cross Slope - Existing (5.0% or more)				
Code Ref:	CBC 1133B.7.1.3 and ADA/ABA 403.3

As Built Meas:	428	Quantity:	LF
Description:	Cross slope exceeds 2.0% (5.0% or more)		
As Built Desc:	5.6% cross slope		
Solution:	Demolish existing and construct new route		
Bar. Severity:	1 Necessary	Cost Estimate:	\$53,500.00
Implementation Priority:	4	Facility Function:	
Implementation Phase:		Implementation Date:	
Official Responsible:

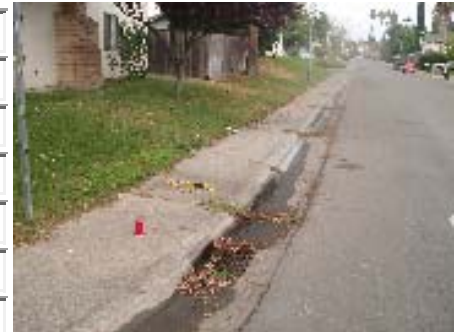
Field Date:	#####	Report Date:	10/18/2010	Barrier #:	855
Location:	Windjammer Wy - East				
X Coordinate:	-121.32433				
Y Coordinate:	38.69908				
Barrier Area:	Sidewalks				
Barrier Type:	Cross Slope - Existing (4.1% to 4.9%)				
Code Ref:	CBC 1133B.7.1.3 and ADA/ABA 403.3

As Built Meas:	183	Quantity:	LF
Description:	Cross slope exceeds 2.0% (4.1% to 4.9%)		
As Built Desc:	4.2% cross slope		
Solution:	Demolish existing and construct new route		
Bar. Severity:	2 Recommended	Cost Estimate:	\$22,875.00
Implementation Priority:	4	Facility Function:	
Implementation Phase:		Implementation Date:	
Official Responsible:

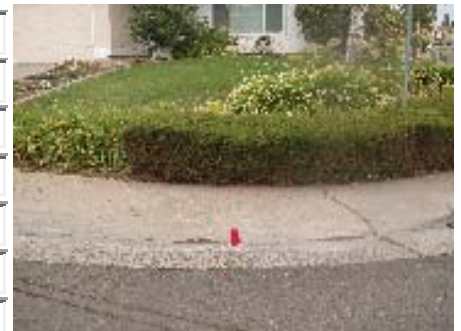
Field Date:	#####	Report Date:	10/18/2010	Barrier #:	856
Location:	Windjammer Wy and Whaler Ct - Corner A				
X Coordinate:	-121.3244				
Y Coordinate:	38.69969				
Barrier Area:	Curb Ramps				
Barrier Type:	No Curb Ramp - Depressed Existing Curb				
Code Ref:	CBC 1127B.5.1 and ADA/ABA 402.2

As Built Meas:	1	Quantity:	EACH
Description:	No compliant curb cut at corner (intersection)		
As Built Desc:	9.4% running slope at depressed area		
Solution:	Demolish existing and construct curb cut		
Bar. Severity:	1 Necessary	Cost Estimate:	\$2,500.00
Implementation Priority:	4	Facility Function:	
Implementation Phase:		Implementation Date:	
Official Responsible:

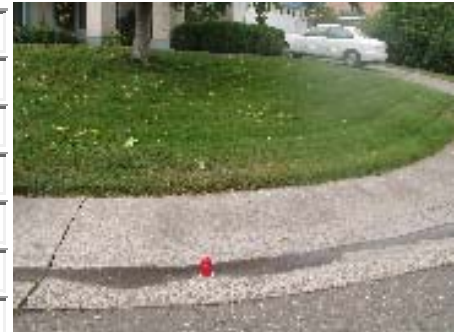
Field Date:	#####	Report Date:	10/18/2010	Barrier #:	857
Location:	Windjammer Wy and Whaler Ct - Corner D				
X Coordinate:	-121.32435				
Y Coordinate:	38.69958				
Barrier Area:	Curb Ramps				
Barrier Type:	No Curb Ramp - Depressed Exsiting Curb				
Code Ref:	CBC 1127B.5.1 and ADA/ABA 402.2

As Built Meas:	1	Quantity:	EACH
Description:	No compliant curb cut at corner (intersection)		
As Built Desc:	8.7% running slope at depressed area		
Solution:	Demolish existing and construct curb cut		
Bar. Severity:	1 Necessary	Cost Estimate:	\$2,500.00
Implementation Priority:	4	Facility Function:	
Implementation Phase:		Implementation Date:	
Official Responsible:			
Notes:	Two - way intersection corners A,D

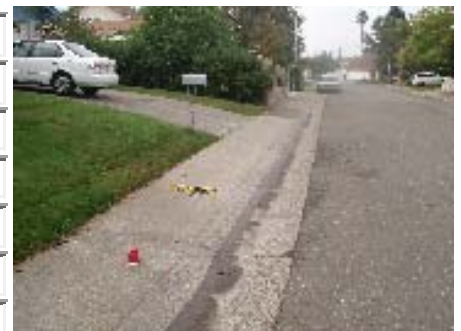
Field Date:	#####	Report Date:	10/18/2010	Barrier #:	858
Location:	Whaler Ct - South				
X Coordinate:	-121.32444				
Y Coordinate:	38.69961				
Barrier Area:	Sidewalks				
Barrier Type:	Cross Slope - Existing (3.1% to 4.0%)				
Code Ref:	CBC 1133B.7.1.3 and ADA/ABA 403.3

As Built Meas:	315	Quantity:	LF
Description:	Cross slope exceeds 2.0% (3.1% to 4.0%)		
As Built Desc:	4.0% cross slope		
Solution:	Demolish existing and construct new route		
Bar. Severity:	3 Hindrance	Cost Estimate:	\$39,375.00
Implementation Priority:	4	Facility Function:	
Implementation Phase:		Implementation Date:	
Official Responsible:			
Notes:

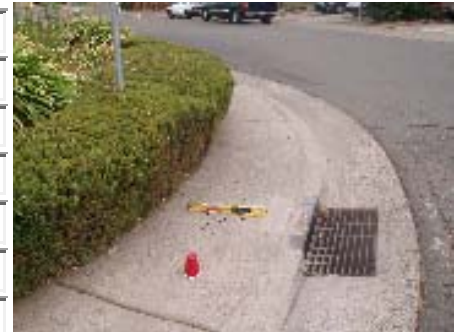
Barrier Type: Clear Width - Existing (32" to 35")

Description: Pedestrian route is not min. 48" wide (32" to 35")

Bar. Severity: 2 Recommended Cost Estimate: \$125.00 Status:

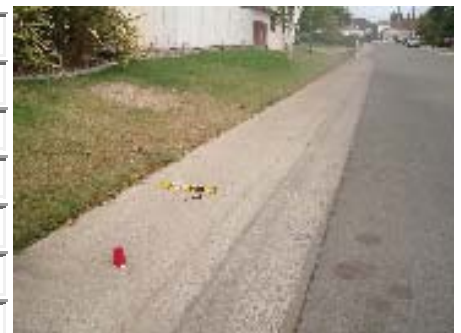
Barrier Type: Cross Slope - Existing (3.1% to 4.0%)

Description: Cross slope exceeds 2.0% (3.1% to 4.0%)

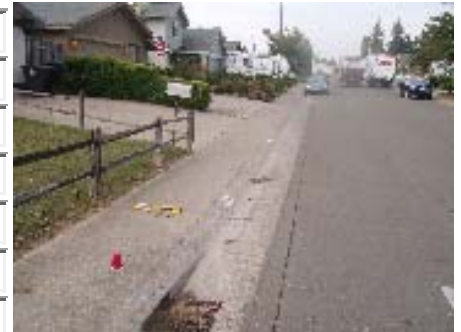
Field Date:	#####	Report Date:	10/18/2010	Barrier #:	861A
Location:	Trawler Wy - South				
X Coordinate:	-121.32444				
Y Coordinate:	38.70027				
Barrier Area:	Sidewalks				
Barrier Type:	Cross Slope - Existing (5.0% or more)				
Code Ref:	CBC 1133B.7.1.3 and ADA/ABA 403.3

As Built Meas:	531	Quantity:	LF		
Description:	Cross slope exceeds 2.0% (5.0% or more)				
As Built Desc:	5.5% cross slope				
Solution:	Demolish existing and construct new route				
Bar. Severity:	1 Necessary	Cost Estimate:	\$66,375.00	Status:	
Implementation Priority:	4	Facility Function:			
Implementation Phase:		Implementation Date:			
Official Responsible:					
Notes:

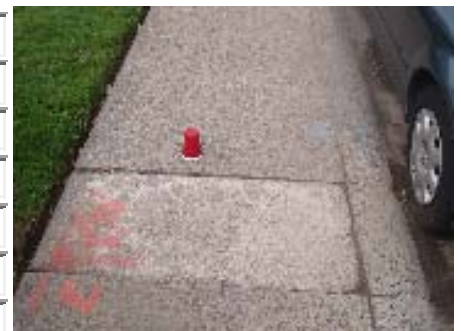
Field Date:	#####	Report Date:	10/18/2010	Barrier #:	861B
Location:	Trawler Wy - South				
X Coordinate:	-121.3248				
Y Coordinate:	38.70026				
Barrier Area:	Sidewalks				
Barrier Type:	Abrupt Change in Level - > 1/2"				
Code Ref:	CBC 1133B.7.1 and ADA/ABA 303.3

As Built Meas:	4	Quantity:	LF		
Description:	Change in level greater than 1/2"				
As Built Desc:	1/2" lip in sidewalk surface				
Solution:	Grind or repair sidewalk to remove trip hazard				
Bar. Severity:	1 Necessary	Cost Estimate:	\$1,000.00	Status:	
Implementation Priority:	4	Facility Function:			
Implementation Phase:		Implementation Date:			
Official Responsible:					
Notes:

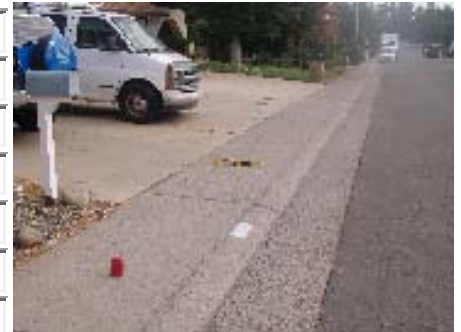
Barrier Type: Cross Slope - Existing (3.1% to 4.0%)

Description: Cross slope exceeds 2.0% (3.1% to 4.0%)

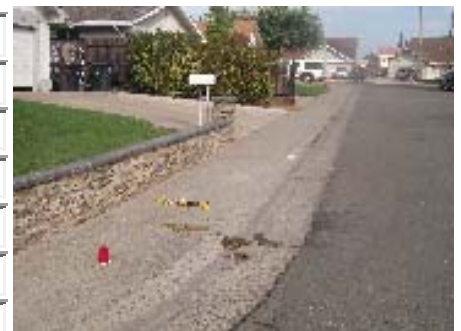
Barrier Type: Cross Slope - Existing (3.1% to 4.0%)

Description: Cross slope exceeds 2.0% (3.1% to 4.0%)

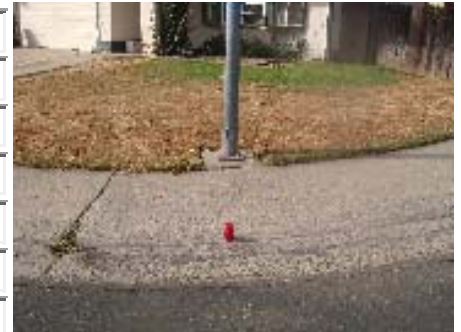
Field Date:	#####	Report Date:	10/18/2010	Barrier #:	864
Location:	Windjammer Wy - West				
X Coordinate:	-121.32435				
Y Coordinate:	38.70091				
Barrier Area:	Sidewalks				
Barrier Type:	Elbow in Sidewalk - Cross Slope (5.0% or more)				
Code Ref:	CBC 1133B.7.1.3 and ADA/ABA 403.3

As Built Meas:	10	Quantity:	LF
Description:	Cross slope at elbow exceeds 2.0% (5.0% or more)		
As Built Desc:	10.9% cross slope		
Solution:	Demolish existing and construct new sidewalk without curb ramp		
Bar. Severity:	1 Necessary	Cost Estimate:	\$1,250.00
Implementation Priority:	4	Facility Function:	
Implementation Phase:		Implementation Date:	
Official Responsible:			
Notes:

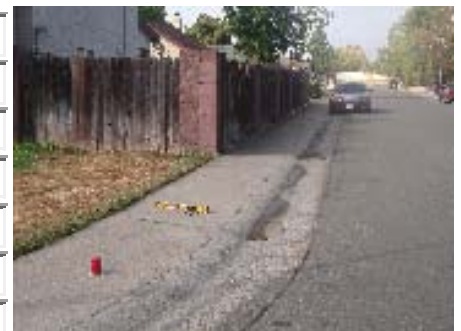
Field Date:	#####	Report Date:	10/18/2010	Barrier #:	865
Location:	Windjammer Wy - South				
X Coordinate:	-121.3244				
Y Coordinate:	38.70093				
Barrier Area:	Sidewalks				
Barrier Type:	Cross Slope - Existing (4.1% to 4.9%)				
Code Ref:	CBC 1133B.7.1.3 and ADA/ABA 403.3

As Built Meas:	520	Quantity:	LF
Description:	Cross slope exceeds 2.0% (4.1% to 4.9%)		
As Built Desc:	4.3% cross slope		
Solution:	Demolish existing and construct new route		
Bar. Severity:	2 Recommended	Cost Estimate:	\$65,000.00
Implementation Priority:	4	Facility Function:	
Implementation Phase:		Implementation Date:	
Official Responsible:			
Notes:

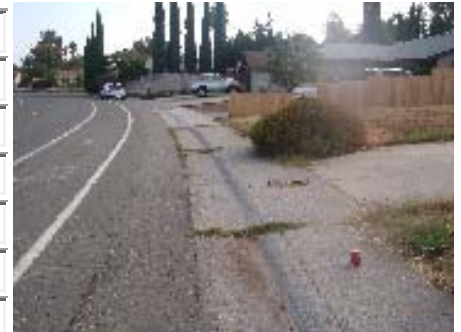
Barrier Type: Cross Slope - Existing (4.1% to 4.9%)

Description: Cross slope exceeds 2.0% (4.1% to 4.9%)

Bar. Severity: 2 Recommended Cost Estimate: \$33,000.00 Status:

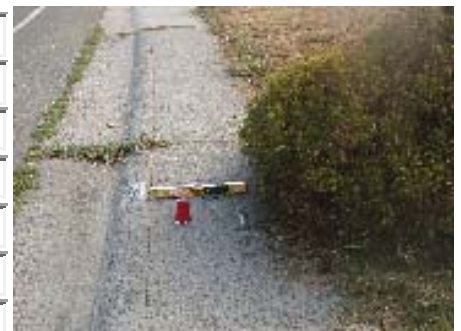
Barrier Type: Clear Width - Existing ($\leq 31"$ or less)

Description: Pedestrian route is not min. 48" wide ($\leq 31"$ or less)

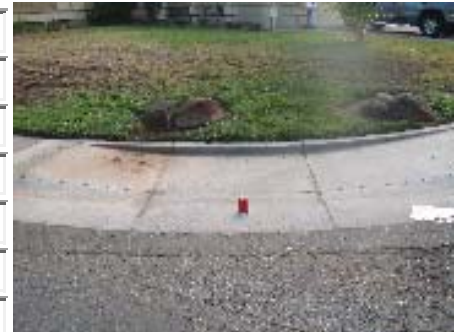
Barrier Type: Detectable Warnings - Truncated Domes

Description: No truncated domes provided at curb ramp

Bar. Severity: 2 Recommended

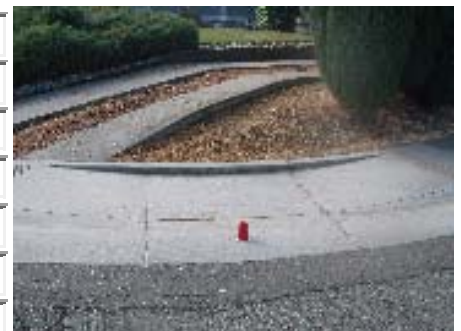
Barrier Type: 12" Grooves - Existing (3.1% to 4.0%)

Description: 12" grooves at top of curb ramp are not level (3.1% to 4.0%)

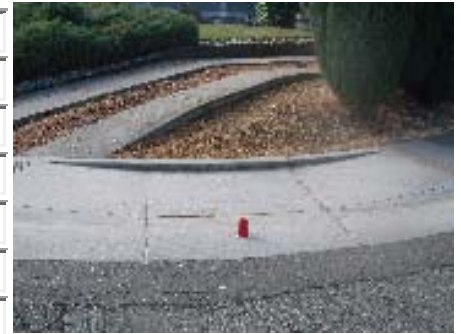
Barrier Type: Detectable Warnings - Truncated Domes

Description: No truncated domes provided at curb ramp

Bar. Severity: 2 Recommended

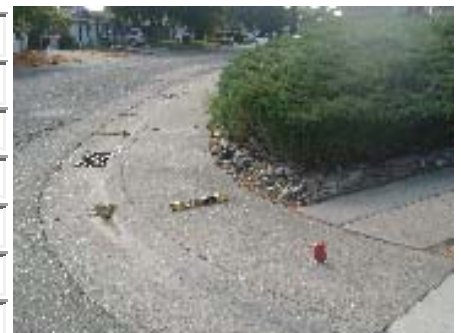
Barrier Type: Cross Slope - Existing (5.0% or more)

Description: Cross slope exceeds 2.0% (5.0% or more)

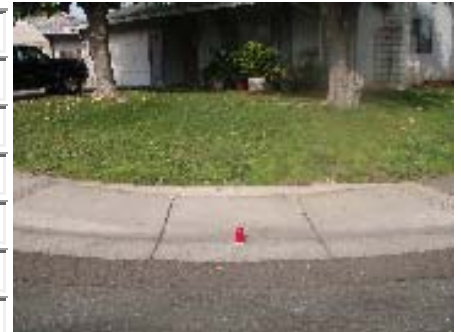
Field Date:	#####	Report Date:	10/18/2010	Barrier #:	870
Location:	Catamaran Dr and Catboat Cir - Corner A				
X Coordinate:	-121.32529				
Y Coordinate:	38.69787				
Barrier Area:	Curb Ramps				
Barrier Type:	Detectable Warnings - Truncated Domes				
Code Ref:	CBC 1127B.5.7 and ADA/ABA 705.1.3

As Built Meas:	1	Quantity:	EACH		
Description:	No truncated domes provided at curb ramp				
As Built Desc:	No detectable warnings at curb ramp				
Solution:	Provide compliant truncated domes				
Bar. Severity:	2 Recommended	Cost Estimate:	\$1,400.00	Status:	
Implementation Priority:	4	Facility Function:			
Implementation Phase:		Implementation Date:			
Official Responsible:					
Notes:	Two - way intersection corners A,D

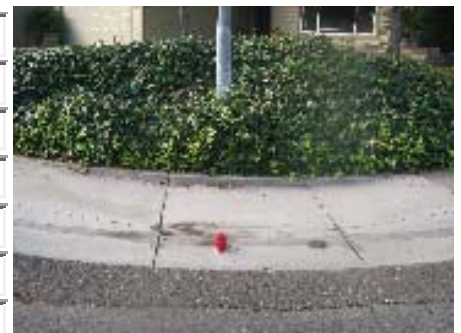
Field Date:	#####	Report Date:	10/18/2010	Barrier #:	871A
Location:	Catamaran Dr and Catboat Cir - Corner D				
X Coordinate:	-121.32527				
Y Coordinate:	38.69776				
Barrier Area:	Curb Ramps				
Barrier Type:	12" Grooves - Existing (3.1% to 4.0%)				
Code Ref:	CBC 1127B.5.6

As Built Meas:	1	Quantity:	EACH		
Description:	12" grooves at top of curb ramp are not level (3.1% to 4.0%)				
As Built Desc:	3.9% at 12" grooves				
Solution:	Demolish existing and construct new curb ramp				
Bar. Severity:	3 Hindrance	Cost Estimate:	\$2,500.00	Status:	
Implementation Priority:	4	Facility Function:			
Implementation Phase:		Implementation Date:			
Official Responsible:					
Notes:	Two - way intersection corners A,D

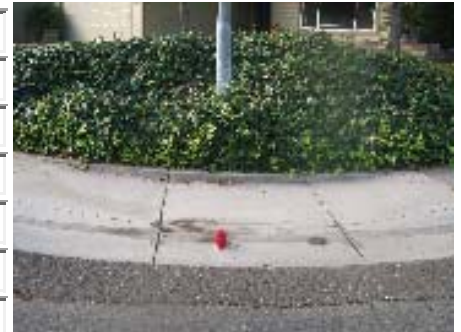
Field Date:	#####	Report Date:	10/18/2010	Barrier #:	871B
Location:	Catamaran Dr and Catboat Cir - Corner D				
X Coordinate:	-121.32527				
Y Coordinate:	38.69776				
Barrier Area:	Curb Ramps				
Barrier Type:	Detectable Warnings - Truncated Domes				
Code Ref:	CBC 1127B.5.7 and ADA/ABA 705.1.3				
As Built Meas:	1	Quantity:	EACH		
Description:	No truncated domes provided at curb ramp				
As Built Desc:	No detectable warnings at curb ramp				
Solution:	Provide compliant truncated domes				
Bar. Severity:	2 Recommended	Cost Estimate:	\$0.00	Status:	
Implementation Priority:	4	Facility Function:			
Implementation Phase:		Implementation Date:			
Official Responsible:					
Notes:	Two - way intersection corners A,D

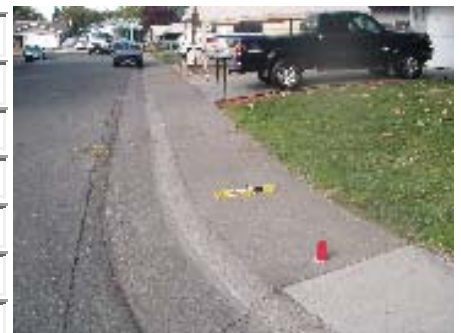
Field Date:	#####	Report Date:	10/18/2010	Barrier #:	872
Location:	Catboat Cir - North				
X Coordinate:	-121.32536				
Y Coordinate:	38.69787				
Barrier Area:	Sidewalks				
Barrier Type:	Cross Slope - Existing (4.1% to 4.9%)				
Code Ref:	CBC 1133B.7.1.3 and ADA/ABA 403.3				
As Built Meas:	221	Quantity:	LF		
Description:	Cross slope exceeds 2.0% (4.1% to 4.9%)				
As Built Desc:	4.7% cross slope				
Solution:	Demolish existing and construct new route				
Bar. Severity:	2 Recommended	Cost Estimate:	\$27,625.00	Status:	
Implementation Priority:	4	Facility Function:			
Implementation Phase:		Implementation Date:			
Official Responsible:					
Notes:

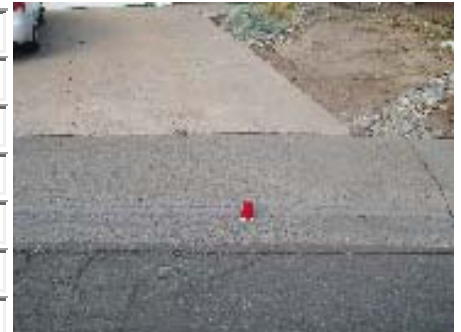
Field Date:	#####	Report Date:	10/18/2010	Barrier #:	873
Location:	Catboat Cir - North				
X Coordinate:	-121.32612				
Y Coordinate:	38.69785				
Barrier Area:	Sidewalks				
Barrier Type:	Elbow in Sidewalk - Cross Slope (5.0% or more)				
Code Ref:	CBC 1133B.7.1.3 and ADA/ABA 403.3

As Built Meas:	10	Quantity:	LF		
Description:	Cross slope at elbow exceeds 2.0% (5.0% or more)				
As Built Desc:	8.1% cross slope				
Solution:	Demolish existing and construct new sidewalk without curb ramp				
Bar. Severity:	1 Necessary	Cost Estimate:	\$1,250.00	Status:	
Implementation Priority:	4	Facility Function:			
Implementation Phase:		Implementation Date:			
Official Responsible:					
Notes:

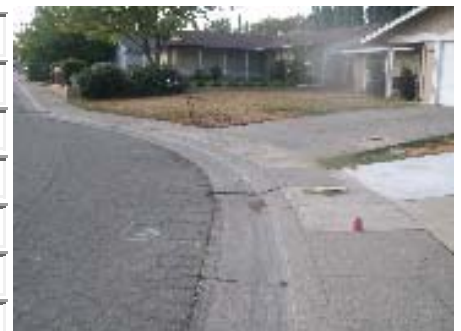
Field Date:	#####	Report Date:	10/18/2010	Barrier #:	874
Location:	Catboat Cir - West				
X Coordinate:	-121.32615				
Y Coordinate:	38.69781				
Barrier Area:	Sidewalks				
Barrier Type:	Cross Slope - Existing (4.1% to 4.9%)				
Code Ref:	CBC 1133B.7.1.3 and ADA/ABA 403.3

As Built Meas:	470	Quantity:	LF		
Description:	Cross slope exceeds 2.0% (4.1% to 4.9%)				
As Built Desc:	4.2% cross slope				
Solution:	Demolish existing and construct new route				
Bar. Severity:	2 Recommended	Cost Estimate:	\$58,750.00	Status:	
Implementation Priority:	4	Facility Function:			
Implementation Phase:		Implementation Date:			
Official Responsible:					
Notes:

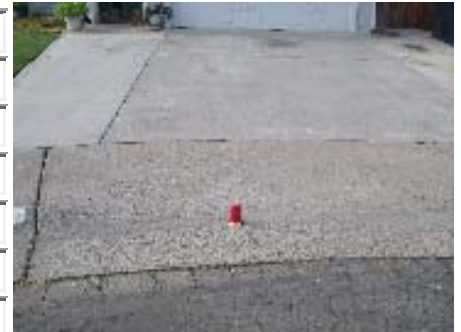
Field Date:	#####	Report Date:	10/18/2010	Barrier #:	875
Location:	Catboat Cir - West				
X Coordinate:	-121.32615				
Y Coordinate:	38.69651				
Barrier Area:	Sidewalks				
Barrier Type:	Elbow in Sidewalk - Cross Slope (5.0% or more)				
Code Ref:	CBC 1133B.7.1.3 and ADA/ABA 403.3

As Built Meas:	10	Quantity:	LF
Description:	Cross slope at elbow exceeds 2.0% (5.0% or more)		
As Built Desc:	12.5% cross slope		
Solution:	Demolish existing and construct new sidewalk without curb ramp		
Bar. Severity:	1 Necessary	Cost Estimate:	\$1,250.00
Implementation Priority:	4	Facility Function:	
Implementation Phase:		Implementation Date:	
Official Responsible:			
Notes:

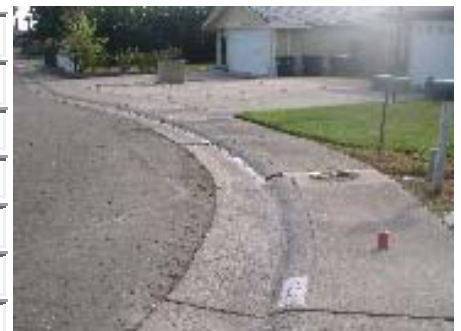
Field Date:	#####	Report Date:	10/18/2010	Barrier #:	876
Location:	Catboat Cir - South				
X Coordinate:	-121.32615				
Y Coordinate:	38.69651				
Barrier Area:	Sidewalks				
Barrier Type:	Cross Slope - Existing (5.0% or more)				
Code Ref:	CBC 1133B.7.1.3 and ADA/ABA 403.3

As Built Meas:	215	Quantity:	LF
Description:	Cross slope exceeds 2.0% (5.0% or more)		
As Built Desc:	5.3% cross slope		
Solution:	Demolish existing and construct new route		
Bar. Severity:	1 Necessary	Cost Estimate:	\$26,875.00
Implementation Priority:	4	Facility Function:	
Implementation Phase:		Implementation Date:	
Official Responsible:			
Notes:

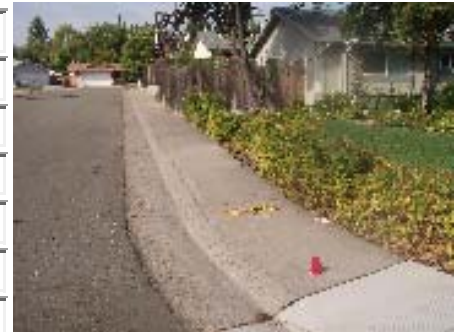
Field Date:	#####	Report Date:	10/18/2010	Barrier #:	877
Location:	Catboat Cir - North				
X Coordinate:	-121.32537				
Y Coordinate:	38.69661				
Barrier Area:	Sidewalks				
Barrier Type:	Cross Slope - Existing (5.0% or more)				
Code Ref:	CBC 1133B.7.1.3 and ADA/ABA 403.3

As Built Meas:	183	Quantity:	LF
Description:	Cross slope exceeds 2.0% (5.0% or more)		
As Built Desc:	5.1% cross slope		
Solution:	Demolish existing and construct new route		
Bar. Severity:	1 Necessary	Cost Estimate:	\$22,875.00
Implementation Priority:	4	Facility Function:	
Implementation Phase:		Implementation Date:	
Official Responsible:			
Notes:

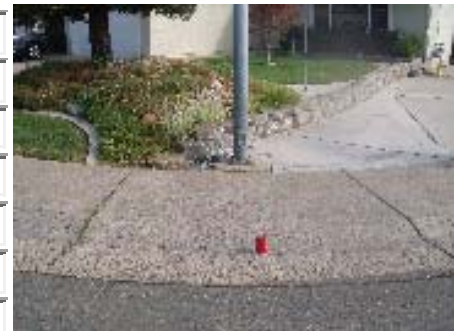
Field Date:	#####	Report Date:	10/18/2010	Barrier #:	878
Location:	Catboat Cir - North				
X Coordinate:	-121.32599				
Y Coordinate:	38.69664				
Barrier Area:	Sidewalks				
Barrier Type:	Elbow in Sidewalk - Cross Slope (5.0% or more)				
Code Ref:	CBC 1133B.7.1.3 and ADA/ABA 403.3

As Built Meas:	10	Quantity:	LF
Description:	Cross slope at elbow exceeds 2.0% (5.0% or more)		
As Built Desc:	10.5% cross slope		
Solution:	Demolish existing and construct new sidewalk without curb ramp		
Bar. Severity:	1 Necessary	Cost Estimate:	\$1,250.00
Implementation Priority:	4	Facility Function:	
Implementation Phase:		Implementation Date:	
Official Responsible:			
Notes:

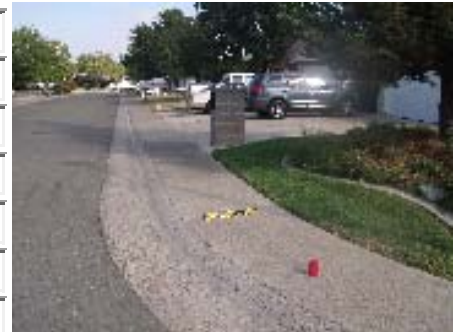
Field Date:	#####	Report Date:	10/18/2010	Barrier #:	879
Location:	Catboat Cir - East				
X Coordinate:	-121.32601				
Y Coordinate:	38.69665				
Barrier Area:	Sidewalks				
Barrier Type:	Cross Slope - Existing (4.1% to 4.9%)				
Code Ref:	CBC 1133B.7.1.3 and ADA/ABA 403.3

As Built Meas:	415	Quantity:	LF	
Description:	Cross slope exceeds 2.0% (4.1% to 4.9%)			
As Built Desc:	4.2% cross slope			
Solution:	Demolish existing and construct new route			
Bar. Severity:	2 Recommended	Cost Estimate:	\$51,875.00	Status:
Implementation Priority:	4	Facility Function:		
Implementation Phase:		Implementation Date:		
Official Responsible:				
Notes:

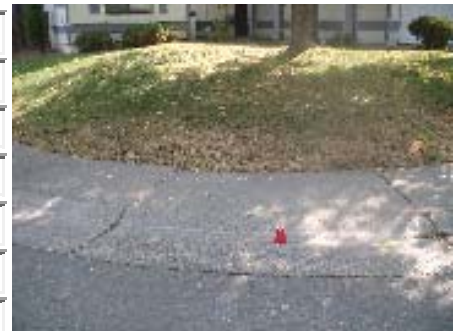
Field Date:	#####	Report Date:	10/18/2010	Barrier #:	880
Location:	Catboat Cir - East				
X Coordinate:	-121.32599				
Y Coordinate:	38.69775				
Barrier Area:	Sidewalks				
Barrier Type:	Elbow in Sidewalk - Cross Slope (5.0% or more)				
Code Ref:	CBC 1133B.7.1.3 and ADA/ABA 403.3

As Built Meas:	10	Quantity:	LF	
Description:	Cross slope at elbow exceeds 2.0% (5.0% or more)			
As Built Desc:	11.7% cross slope			
Solution:	Demolish existing and construct new sidewalk without curb ramp			
Bar. Severity:	1 Necessary	Cost Estimate:	\$1,250.00	Status:
Implementation Priority:	4	Facility Function:		
Implementation Phase:		Implementation Date:		
Official Responsible:				
Notes:

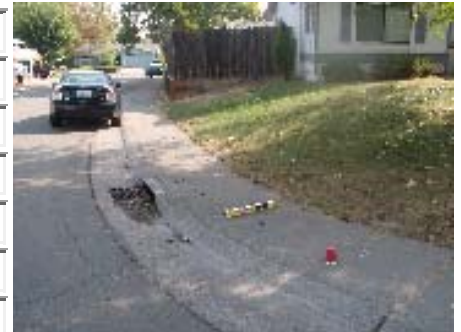
Field Date:	#####	Report Date:	10/18/2010	Barrier #:	881
Location:	Catboat Cir - South				
X Coordinate:	-121.32596				
Y Coordinate:	38.69776				
Barrier Area:	Sidewalks				
Barrier Type:	Cross Slope - Existing (5.0% or more)				
Code Ref:	CBC 1133B.7.1.3 and ADA/ABA 403.3

As Built Meas:	185	Quantity:	LF
Description:	Cross slope exceeds 2.0% (5.0% or more)		
As Built Desc:	5.5% cross slope		
Solution:	Demolish existing and construct new route		
Bar. Severity:	1 Necessary	Cost Estimate:	\$23,125.00
Implementation Priority:	4	Facility Function:	
Implementation Phase:		Implementation Date:	
Official Responsible:			
Notes:

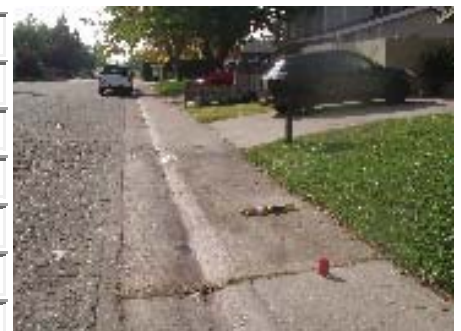
Field Date:	#####	Report Date:	10/18/2010	Barrier #:	882
Location:	Catamaran Dr - West				
X Coordinate:	-121.32526				
Y Coordinate:	38.69771				
Barrier Area:	Sidewalks				
Barrier Type:	Cross Slope - Existing (4.1% to 4.9%)				
Code Ref:	CBC 1133B.7.1.3 and ADA/ABA 403.3

As Built Meas:	412	Quantity:	LF
Description:	Cross slope exceeds 2.0% (4.1% to 4.9%)		
As Built Desc:	4.4% cross slope		
Solution:	Demolish existing and construct new route		
Bar. Severity:	2 Recommended	Cost Estimate:	\$51,500.00
Implementation Priority:	4	Facility Function:	
Implementation Phase:		Implementation Date:	
Official Responsible:			
Notes:

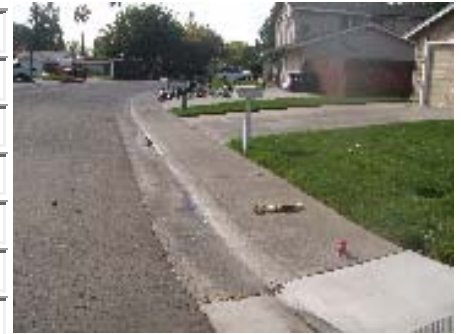
Field Date:	#####	Report Date:	10/18/2010	Barrier #:	883
Location:	Catamaran Dr - West				
X Coordinate:	-121.32529				
Y Coordinate:	38.69643				
Barrier Area:	Sidewalks				
Barrier Type:	Cross Slope - Existing (4.1% to 4.9%)				
Code Ref:	CBC 1133B.7.1.3 and ADA/ABA 403.3

As Built Meas:	330	Quantity:	LF
Description:	Cross slope exceeds 2.0% (4.1% to 4.9%)		
As Built Desc:	4.4% cross slope		
Solution:	Demolish existing and construct new route		
Bar. Severity:	2 Recommended	Cost Estimate:	\$41,250.00
Implementation Priority:	4	Facility Function:	
Implementation Phase:		Implementation Date:	
Official Responsible:

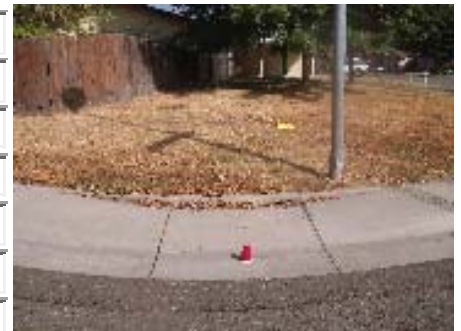
Field Date:	#####	Report Date:	10/18/2010	Barrier #:	884
Location:	Catamaran Dr and Yawl Ct - Corner A				
X Coordinate:	-121.32574				
Y Coordinate:	38.69561				
Barrier Area:	Curb Ramps				
Barrier Type:	Detectable Warnings - Truncated Domes				
Code Ref:	CBC 1127B.5.7 and ADA/ABA 705.1.3

As Built Meas:	1	Quantity:	EACH
Description:	No truncated domes provided at curb ramp		
As Built Desc:	No detectable warnings at curb ramp		
Solution:	Provide compliant truncated domes		
Bar. Severity:	2 Recommended	Cost Estimate:	\$1,400.00
Implementation Priority:	4	Facility Function:	
Implementation Phase:		Implementation Date:	
Official Responsible:

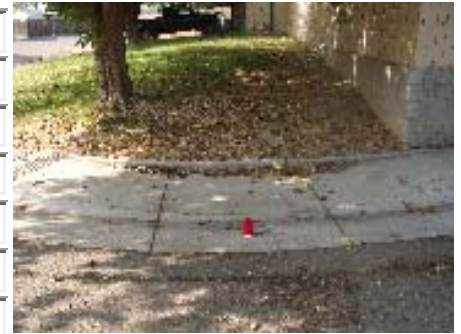
Field Date:	#####	Report Date:	10/18/2010	Barrier #:	885
Location:	Catamaran Dr and Yawl Ct - Corner D				
X Coordinate:	-121.32586				
Y Coordinate:	38.69554				
Barrier Area:	Curb Ramps				
Barrier Type:	Detectable Warnings - Truncated Domes				
Code Ref:	CBC 1127B.5.7 and ADA/ABA 705.1.3

As Built Meas:	1	Quantity:	EACH
Description:	No truncated domes provided at curb ramp		
As Built Desc:	No detectable warnings at curb ramp		
Solution:	Provide compliant truncated domes		
Bar. Severity:	2 Recommended	Cost Estimate:	\$1,400.00
Implementation Priority:	4	Facility Function:	
Implementation Phase:		Implementation Date:	
Official Responsible:			
Notes:	Two - way intersection corners A,D

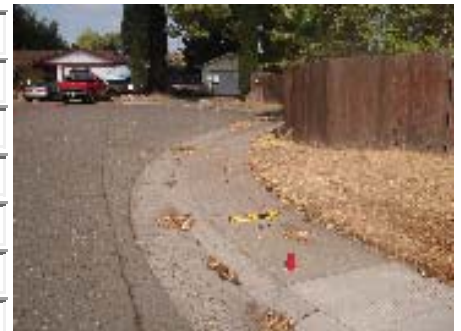
Field Date:	#####	Report Date:	10/18/2010	Barrier #:	886
Location:	Yawl Ct - North				
X Coordinate:	-121.32578				
Y Coordinate:	38.6956				
Barrier Area:	Sidewalks				
Barrier Type:	Cross Slope - Existing (4.1% to 4.9%)				
Code Ref:	CBC 1133B.7.1.3 and ADA/ABA 403.3

As Built Meas:	158	Quantity:	LF
Description:	Cross slope exceeds 2.0% (4.1% to 4.9%)		
As Built Desc:	4.4% cross slope		
Solution:	Demolish existing and construct new route		
Bar. Severity:	2 Recommended	Cost Estimate:	\$19,750.00
Implementation Priority:	4	Facility Function:	
Implementation Phase:		Implementation Date:	
Official Responsible:			
Notes:

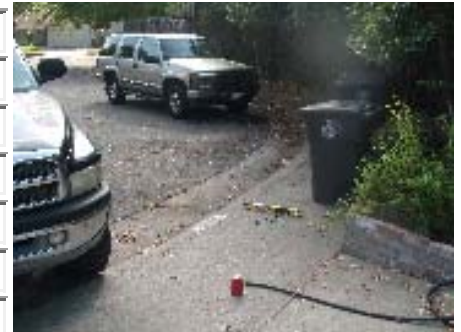
Field Date:	#####	Report Date:	10/18/2010	Barrier #:	887
Location:	Yawl Ct - South				
X Coordinate:	-121.32612				
Y Coordinate:	38.69575				
Barrier Area:	Sidewalks				
Barrier Type:	Cross Slope - Existing (4.1% to 4.9%)				
Code Ref:	CBC 1133B.7.1.3 and ADA/ABA 403.3

As Built Meas:	95	Quantity:	LF
Description:	Cross slope exceeds 2.0% (4.1% to 4.9%)		
As Built Desc:	4.9% cross slope		
Solution:	Demolish existing and construct new route		
Bar. Severity:	2 Recommended	Cost Estimate:	\$11,875.00
Implementation Priority:	4	Facility Function:	
Implementation Phase:		Implementation Date:	
Official Responsible:			
Notes:

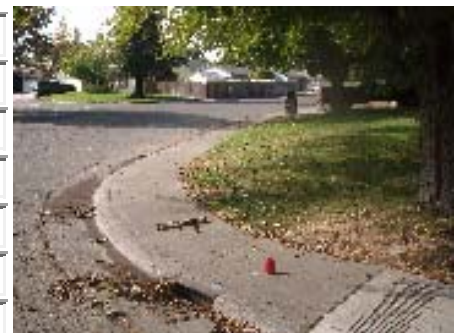
Field Date:	#####	Report Date:	10/18/2010	Barrier #:	888
Location:	Catamaran Dr - West				
X Coordinate:	-121.32585				
Y Coordinate:	38.69553				
Barrier Area:	Sidewalks				
Barrier Type:	Cross Slope - Existing (4.1% to 4.9%)				
Code Ref:	CBC 1133B.7.1.3 and ADA/ABA 403.3

As Built Meas:	177	Quantity:	LF
Description:	Cross slope exceeds 2.0% (4.1% to 4.9%)		
As Built Desc:	4.6% cross slope		
Solution:	Demolish existing and construct new route		
Bar. Severity:	2 Recommended	Cost Estimate:	\$22,125.00
Implementation Priority:	4	Facility Function:	
Implementation Phase:		Implementation Date:	
Official Responsible:			
Notes:

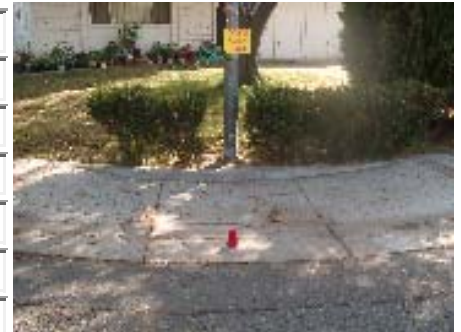
Field Date:	#####	Report Date:	10/18/2010	Barrier #:	889
Location:	Catamaran Dr and Pikes Peak Wy - Corner B				
X Coordinate:	-121.32599				
Y Coordinate:	38.6953				
Barrier Area:	Curb Ramps				
Barrier Type:	Detectable Warnings - Truncated Domes				
Code Ref:	CBC 1127B.5.7 and ADA/ABA 705.1.3

As Built Meas:	1	Quantity:	EACH
Description:	No truncated domes provided at curb ramp		
As Built Desc:	No detectable warnings at curb ramp		
Solution:	Provide compliant truncated domes		
Bar. Severity:	2 Recommended	Cost Estimate:	\$1,400.00
Implementation Priority:	4	Facility Function:	
Implementation Phase:		Implementation Date:	
Official Responsible:			
Notes:	Two - way intersection corners B,C

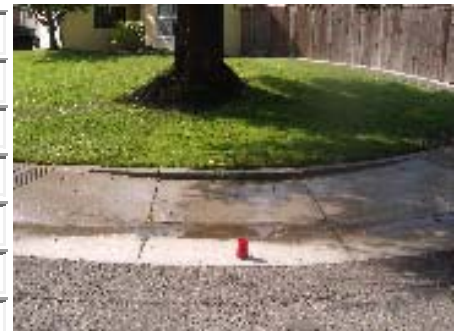
Field Date:	#####	Report Date:	10/18/2010	Barrier #:	890A
Location:	Catamaran Dr and Pikes Peak Wy - Corner C				
X Coordinate:	-121.3262				
Y Coordinate:	38.69525				
Barrier Area:	Curb Ramps				
Barrier Type:	12" Grooves - Existing (4.1% to 4.9%)				
Code Ref:	CBC 1127B.5.6

As Built Meas:	1	Quantity:	EACH
Description:	12" grooves at top of curb ramp are not level (4.1% to 4.9%)		
As Built Desc:	4.1% at 12" grooves		
Solution:	Demolish existing and construct new curb ramp		
Bar. Severity:	2 Recommended	Cost Estimate:	\$2,500.00
Implementation Priority:	4	Facility Function:	
Implementation Phase:		Implementation Date:	
Official Responsible:			
Notes:	Two - way intersection corners B,C

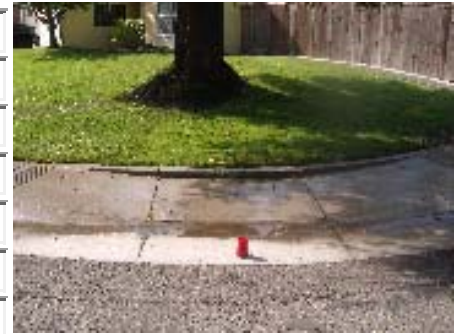
Barrier Type: Detectable Warnings - Truncated Domes

Description: No truncated domes provided at curb ramp

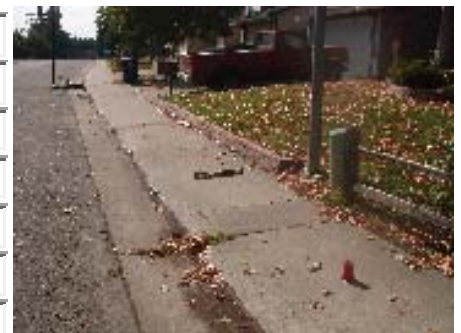
Barrier Type: Cross Slope - Existing (4.1% to 4.9%)

Description: Cross slope exceeds 2.0% (4.1% to 4.9%)

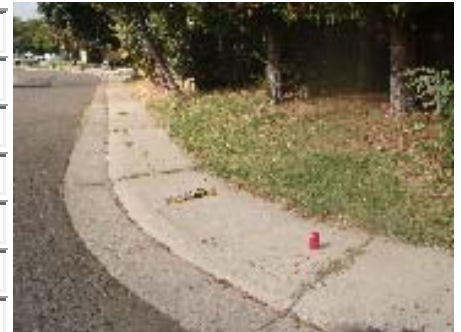
Field Date:	#####	Report Date:	10/18/2010	Barrier #:	892
Location:	Pikes Peak Wy - West				
X Coordinate:	-121.32615				
Y Coordinate:	38.69314				
Barrier Area:	Sidewalks				
Barrier Type:	Cross Slope - Existing (4.1% to 4.9%)				
Code Ref:	CBC 1133B.7.1.3 and ADA/ABA 403.3

As Built Meas:	121	Quantity:	LF
Description:	Cross slope exceeds 2.0% (4.1% to 4.9%)		
As Built Desc:	4.8% cross slope		
Solution:	Demolish existing and construct new route		
Bar. Severity:	2 Recommended	Cost Estimate:	\$15,125.00
Status:			
Implementation Priority:	4	Facility Function:	
Implementation Phase:		Implementation Date:	
Official Responsible:

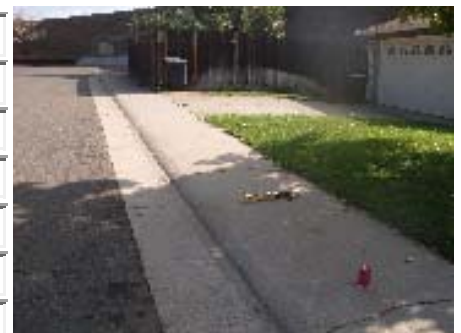
Field Date:	#####	Report Date:	10/18/2010	Barrier #:	893
Location:	Pikes Peak Wy - East				
X Coordinate:	-121.32658				
Y Coordinate:	38.693				
Barrier Area:	Sidewalks				
Barrier Type:	Cross Slope - Existing (4.1% to 4.9%)				
Code Ref:	CBC 1133B.7.1.3 and ADA/ABA 403.3

As Built Meas:	130	Quantity:	LF
Description:	Cross slope exceeds 2.0% (4.1% to 4.9%)		
As Built Desc:	4.1% cross slope		
Solution:	Demolish existing and construct new route		
Bar. Severity:	2 Recommended	Cost Estimate:	\$16,250.00
Status:			
Implementation Priority:	4	Facility Function:	
Implementation Phase:		Implementation Date:	
Official Responsible:

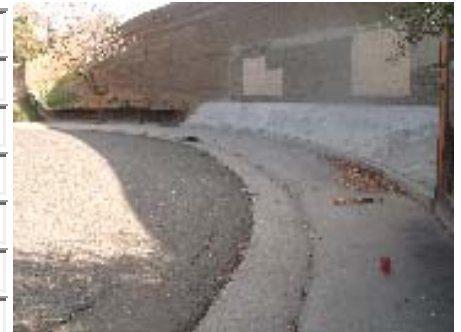
Barrier Type: Cross Slope - Existing (4.1% to 4.9%)

Description: Cross slope exceeds 2.0% (4.1% to 4.9%)

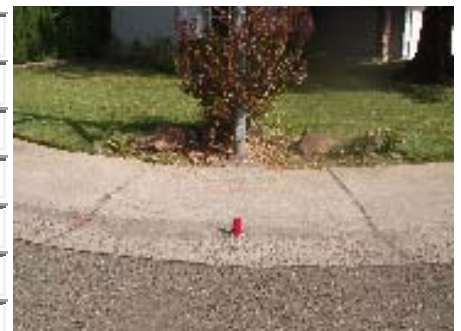
Barrier Type: No Curb Ramp - Depressed Existing Curb

Description: No compliant curb cut at corner (intersection)
