DRAFT ADA TRANSITION PLAN UPDATE
NEIGHBORHOOD AREA 1 NORTHWEST
SEPTEMBER 20, 2011

CITY OF CITRUS HEIGHTS

The Northwest Neighborhood Association

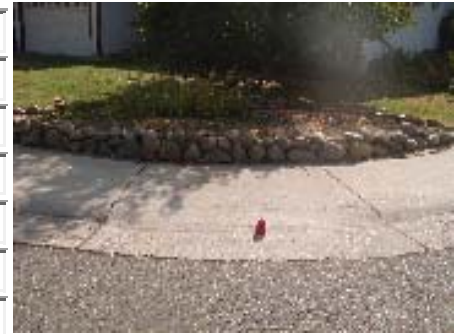
Field Date:	#####	Report Date:	10/18/2010	Barrier #:	896
Location:	Pikes Peak Wy and Sassy Ct - Corner C				
X Coordinate:	-121.32603				
Y Coordinate:	38.69409				
Barrier Area:	Curb Ramps				
Barrier Type:	No Curb Ramp - Depressed Exsiting Curb				
Code Ref:	CBC 1127B.5.1 and ADA/ABA 402.2

As Built Meas:	1	Quantity:	EACH
Description:	No compliant curb cut at corner (intersection)		
As Built Desc:	9.2% running slope at depressed area		
Solution:	Demolish existing and construct curb cut		
Bar. Severity:	1 Necessary	Cost Estimate:	\$2,500.00
Implementation Priority:	4	Facility Function:	
Implementation Phase:		Implementation Date:	
Official Responsible:			
Notes:	Two - way intersection corners B,C

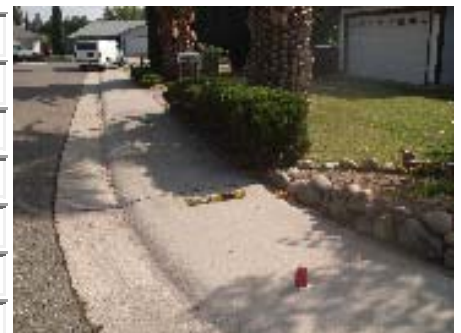
Field Date:	#####	Report Date:	10/18/2010	Barrier #:	897
Location:	Sassy Ct - East				
X Coordinate:	-121.32596				
Y Coordinate:	38.69412				
Barrier Area:	Sidewalks				
Barrier Type:	Cross Slope - Existing (3.1% to 4.0%)				
Code Ref:	CBC 1133B.7.1.3 and ADA/ABA 403.3

As Built Meas:	208	Quantity:	LF
Description:	Cross slope exceeds 2.0% (3.1% to 4.0%)		
As Built Desc:	3.7% cross slope		
Solution:	Demolish existing and construct new route		
Bar. Severity:	3 Hindrance	Cost Estimate:	\$26,000.00
Implementation Priority:	4	Facility Function:	
Implementation Phase:		Implementation Date:	
Official Responsible:			
Notes:

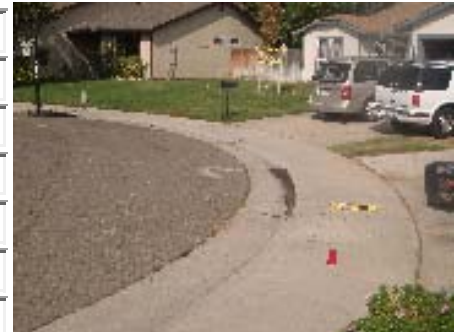
Field Date:	#####	Report Date:	10/18/2010	Barrier #:	898
Location:	Sassy Ct - West				
X Coordinate:	-121.32535				
Y Coordinate:	38.69417				
Barrier Area:	Sidewalks				
Barrier Type:	Cross Slope - Existing (3.1% to 4.0%)				
Code Ref:	CBC 1133B.7.1.3 and ADA/ABA 403.3

As Built Meas:	227	Quantity:	LF
Description:	Cross slope exceeds 2.0% (3.1% to 4.0%)		
As Built Desc:	3.9% cross slope		
Solution:	Demolish existing and construct new route		
Bar. Severity:	3 Hindrance	Cost Estimate:	\$28,375.00
Implementation Priority:	4	Facility Function:	
Implementation Phase:		Implementation Date:	
Official Responsible:

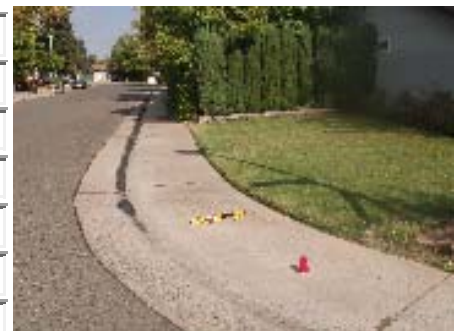
Field Date:	#####	Report Date:	10/18/2010	Barrier #:	899
Location:	Pikes Peak Wy - East				
X Coordinate:	-121.32602				
Y Coordinate:	38.69424				
Barrier Area:	Sidewalks				
Barrier Type:	Cross Slope - Existing (4.1% to 4.9%)				
Code Ref:	CBC 1133B.7.1.3 and ADA/ABA 403.3

As Built Meas:	187	Quantity:	LF
Description:	Cross slope exceeds 2.0% (4.1% to 4.9%)		
As Built Desc:	4.6% cross slope		
Solution:	Demolish existing and construct new route		
Bar. Severity:	2 Recommended	Cost Estimate:	\$23,375.00
Implementation Priority:	4	Facility Function:	
Implementation Phase:		Implementation Date:	
Official Responsible:

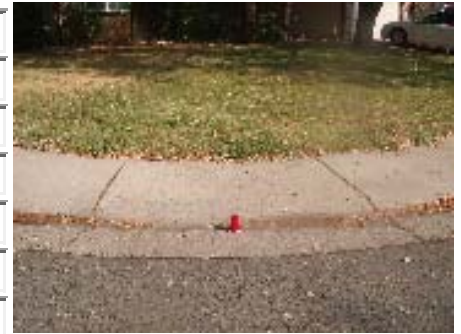
Field Date:	#####	Report Date:	10/18/2010	Barrier #:	900
Location:	Pikes Peak Wy and Desiree Ct - Corner B				
X Coordinate:	-121.32602				
Y Coordinate:	38.69488				
Barrier Area:	Curb Ramps				
Barrier Type:	No Curb Ramp - Depressed Exsiting Curb				
Code Ref:	CBC 1127B.5.1 and ADA/ABA 402.2

As Built Meas:	1	Quantity:	EACH
Description:	No compliant curb cut at corner (intersection)		
As Built Desc:	9.3% running slope at depressed area		
Solution:	Demolish existing and construct curb cut		
Bar. Severity:	1 Necessary	Cost Estimate:	\$2,500.00
Implementation Priority:	4	Facility Function:	
Implementation Phase:		Implementation Date:	
Official Responsible:			
Notes:	Two - way intersection corners B,C

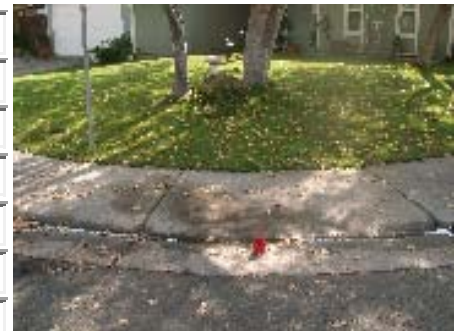
Field Date:	#####	Report Date:	10/18/2010	Barrier #:	901
Location:	Pikes Peak Wy and Desiree Ct - Corner C				
X Coordinate:	-121.32599				
Y Coordinate:	38.69478				
Barrier Area:	Curb Ramps				
Barrier Type:	No Curb Ramp - Depressed Exsiting Curb				
Code Ref:	CBC 1127B.5.1 and ADA/ABA 402.2

As Built Meas:	1	Quantity:	EACH
Description:	No compliant curb cut at corner (intersection)		
As Built Desc:	9.5% running slope at depressed area		
Solution:	Demolish existing and construct curb cut		
Bar. Severity:	1 Necessary	Cost Estimate:	\$2,500.00
Implementation Priority:	4	Facility Function:	
Implementation Phase:		Implementation Date:	
Official Responsible:			
Notes:	Two - way intersection corners B,C

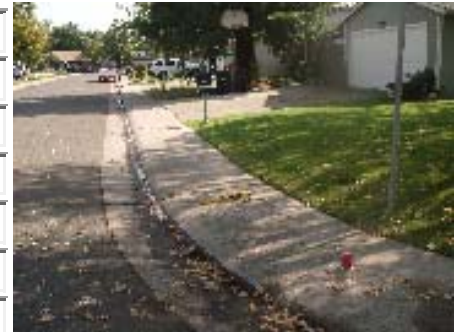
Field Date:	#####	Report Date:	10/18/2010	Barrier #:	902
Location:	Desiree Ct - East				
X Coordinate:	-121.32598				
Y Coordinate:	38.69479				
Barrier Area:	Sidewalks				
Barrier Type:	Cross Slope - Existing (3.1% to 4.0%)				
Code Ref:	CBC 1133B.7.1.3 and ADA/ABA 403.3

As Built Meas:	366	Quantity:	LF		
Description:	Cross slope exceeds 2.0% (3.1% to 4.0%)				
As Built Desc:	3.7% cross slope				
Solution:	Demolish existing and construct new route				
Bar. Severity:	3 Hindrance	Cost Estimate:	\$45,750.00	Status:	
Implementation Priority:	4	Facility Function:			
Implementation Phase:		Implementation Date:			
Official Responsible:					
Notes:

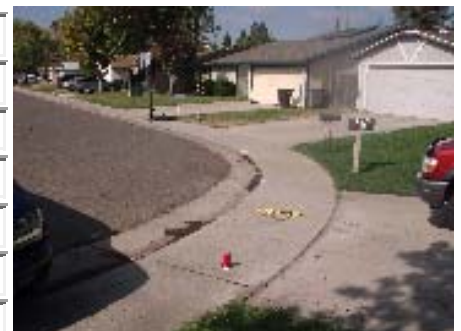
Field Date:	#####	Report Date:	10/18/2010	Barrier #:	903
Location:	Desiree Ct - West				
X Coordinate:	-121.32473				
Y Coordinate:	38.6948				
Barrier Area:	Sidewalks				
Barrier Type:	Cross Slope - Existing (3.1% to 4.0%)				
Code Ref:	CBC 1133B.7.1.3 and ADA/ABA 403.3

As Built Meas:	410	Quantity:	LF		
Description:	Cross slope exceeds 2.0% (3.1% to 4.0%)				
As Built Desc:	3.9% cross slope				
Solution:	Demolish existing and construct new route				
Bar. Severity:	3 Hindrance	Cost Estimate:	\$51,250.00	Status:	
Implementation Priority:	4	Facility Function:			
Implementation Phase:		Implementation Date:			
Official Responsible:					
Notes:

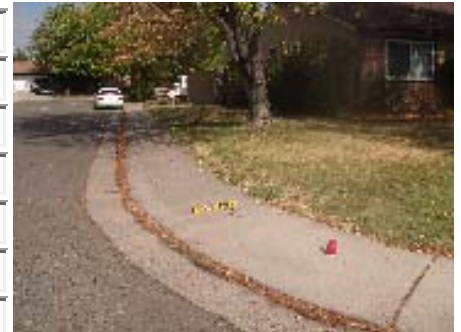
Field Date:	#####	Report Date:	10/18/2010	Barrier #:	904
Location:	Pikes Peak Wy - East				
X Coordinate:	-121.32599				
Y Coordinate:	38.69489				
Barrier Area:	Sidewalks				
Barrier Type:	Cross Slope - Existing (3.1% to 4.0%)				
Code Ref:	CBC 1133B.7.1.3 and ADA/ABA 403.3

As Built Meas:	137	Quantity:	LF	
Description:	Cross slope exceeds 2.0% (3.1% to 4.0%)			
As Built Desc:	4.0% cross slope			
Solution:	Demolish existing and construct new route			
Bar. Severity:	3 Hindrance	Cost Estimate:	\$17,125.00	Status:
Implementation Priority:	4	Facility Function:		
Implementation Phase:		Implementation Date:		
Official Responsible:				
Notes:

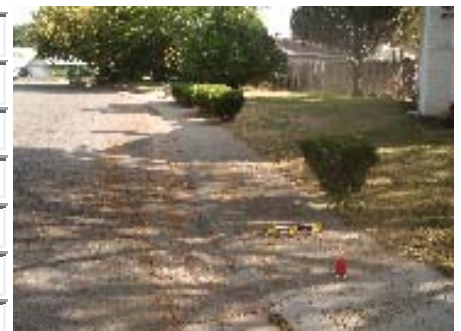
Field Date:	#####	Report Date:	10/18/2010	Barrier #:	905A
Location:	Catamaran Dr - East				
X Coordinate:	-121.32599				
Y Coordinate:	38.69527				
Barrier Area:	Sidewalks				
Barrier Type:	Cross Slope - Existing (5.0% or more)				
Code Ref:	CBC 1133B.7.1.3 and ADA/ABA 403.3

As Built Meas:	222	Quantity:	LF	
Description:	Cross slope exceeds 2.0% (5.0% or more)			
As Built Desc:	5.0% cross slope			
Solution:	Demolish existing and construct new route			
Bar. Severity:	1 Necessary	Cost Estimate:	\$27,750.00	Status:
Implementation Priority:	4	Facility Function:		
Implementation Phase:		Implementation Date:		
Official Responsible:				
Notes:

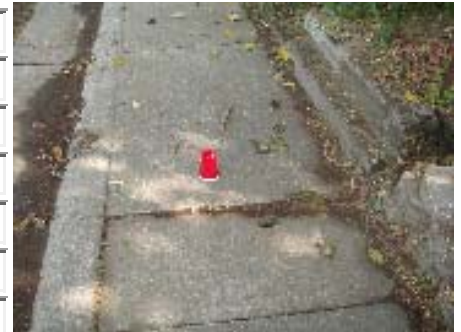
Field Date:	#####	Report Date:	10/18/2010	Barrier #:	905B
Location:	Catamaran Dr - East				
X Coordinate:	-121.32554				
Y Coordinate:	38.69554				
Barrier Area:	Sidewalks				
Barrier Type:	Abrupt Change in Level - Tree Heaves				
Code Ref:	CBC 1133B.7.1 and ADA/ABA 303.3

As Built Meas:	4	Quantity:	LF	
Description:	Change in level greater than 1/2"			
As Built Desc:	1/2" lip due to tree heaves			
Solution:	Grind or repair sidewalk to remove trip hazard			
Bar. Severity:	1 Necessary	Cost Estimate:	\$1,000.00	Status:
Implementation Priority:	4	Facility Function:		
Implementation Phase:		Implementation Date:		
Official Responsible:				
Notes:

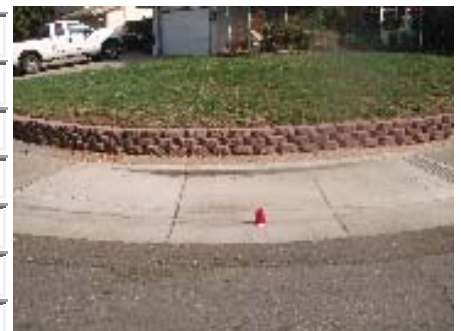
Field Date:	#####	Report Date:	10/18/2010	Barrier #:	906
Location:	Catamaran Dr and Parkvale - Corner B				
X Coordinate:	-121.32528				
Y Coordinate:	38.69577				
Barrier Area:	Curb Ramps				
Barrier Type:	Detectable Warnings - Truncated Domes				
Code Ref:	CBC 1127B.5.7 and ADA/ABA 705.1.3

As Built Meas:	1	Quantity:	EACH	
Description:	No truncated domes provided at curb ramp			
As Built Desc:	No detectable warnings at curb ramp			
Solution:	Provide compliant truncated domes			
Bar. Severity:	2 Recommended	Cost Estimate:	\$1,400.00	Status:
Implementation Priority:	4	Facility Function:		
Implementation Phase:		Implementation Date:		
Official Responsible:				
Notes:	Two - way intersection corners B,C

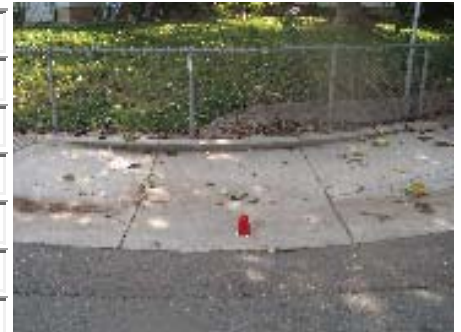
Field Date: ##### Report Date: 10/18/2010 Barrier #: 907

Barrier Type: Detectable Warnings - Truncated Domes

Description: No truncated domes provided at curb ramp

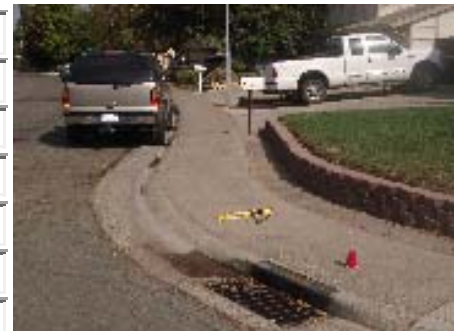
Barrier Type: Cross Slope - Existing (5.0% or more)

Description: Cross slope exceeds 2.0% (5.0% or more)

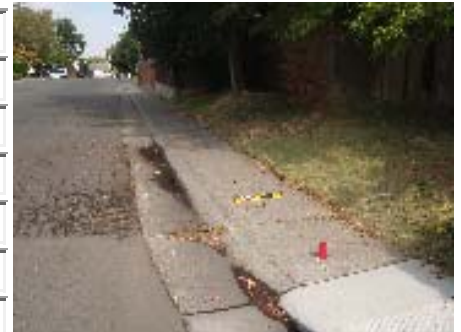
Field Date:	#####	Report Date:	10/18/2010	Barrier #:	909A
Location:	Catamaran Dr - East				
X Coordinate:	-121.32513				
Y Coordinate:	38.6966				
Barrier Area:	Sidewalks				
Barrier Type:	Cross Slope - Existing (5.0% or more)				
Code Ref:	CBC 1133B.7.1.3 and ADA/ABA 403.3

As Built Meas:	184	Quantity:	LF
Description:	Cross slope exceeds 2.0% (5.0% or more)		
As Built Desc:	5.0% cross slope		
Solution:	Demolish existing and construct new route		
Bar. Severity:	1 Necessary	Cost Estimate:	\$23,000.00
Implementation Priority:	4	Facility Function:	
Implementation Phase:		Implementation Date:	
Official Responsible:			
Notes:

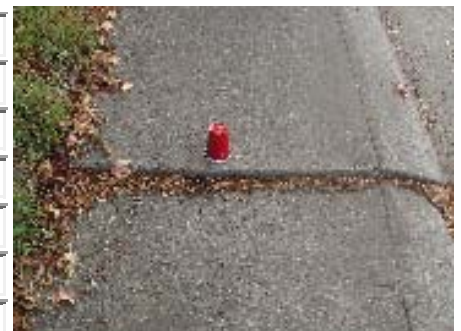
Field Date:	#####	Report Date:	10/18/2010	Barrier #:	909B
Location:	Catamaran Dr - East				
X Coordinate:	-121.3251				
Y Coordinate:	38.69672				
Barrier Area:	Sidewalks				
Barrier Type:	Abrupt Change in Level - Tree Heaves				
Code Ref:	CBC 1133B.7.1 and ADA/ABA 303.3

As Built Meas:	4	Quantity:	LF
Description:	Change in level greater than 1/2"		
As Built Desc:	1/2" lip due to tree heaves		
Solution:	Grind or repair sidewalk to remove trip hazard		
Bar. Severity:	1 Necessary	Cost Estimate:	\$1,000.00
Implementation Priority:	4	Facility Function:	
Implementation Phase:		Implementation Date:	
Official Responsible:			
Notes:

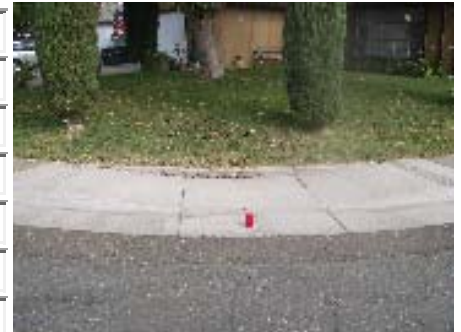
Field Date:	#####	Report Date:	10/18/2010	Barrier #:	910
Location:	Catamaran Dr and Windjammer Wy - Corner B				
X Coordinate:	-121.32513				
Y Coordinate:	38.69725				
Barrier Area:	Curb Ramps				
Barrier Type:	Detectable Warnings - Truncated Domes (New Const)				
Code Ref:	CBC 1127B.5.7 and ADA/ABA 705.1.3

As Built Meas:	1	Quantity:	EACH
Description:	No truncated domes provided at curb ramp		
As Built Desc:	No detectable warnings at curb ramp - New Construction		
Solution:	Provide compliant truncated domes		
Bar. Severity:	1 Necessary	Cost Estimate:	\$1,400.00
Implementation Priority:	4	Facility Function:	
Implementation Phase:		Implementation Date:	
Official Responsible:			
Notes:	Two - way intersection corners B,C

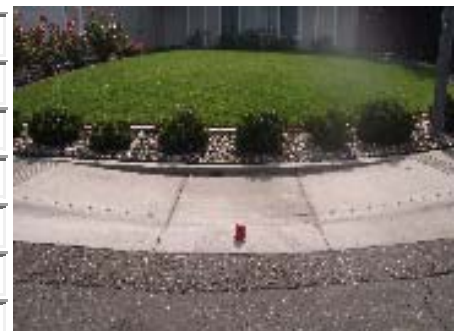
Field Date:	#####	Report Date:	10/18/2010	Barrier #:	911A
Location:	Catamaran Dr and Windjammer Wy - Corner C				
X Coordinate:	-121.32508				
Y Coordinate:	38.69718				
Barrier Area:	Curb Ramps				
Barrier Type:	12" Grooves - New Construction				
Code Ref:	CBC 1127B.5.6

As Built Meas:	1	Quantity:	EACH
Description:	12" grooves at top of curb ramp are not level (3.1% to 4.0%)		
As Built Desc:	3.3% at 12" grooves		
Solution:	Demolish existing and construct new curb ramp		
Bar. Severity:	1 Necessary	Cost Estimate:	\$2,500.00
Implementation Priority:	4	Facility Function:	
Implementation Phase:		Implementation Date:	
Official Responsible:			
Notes:	Two - way intersection corners B,C

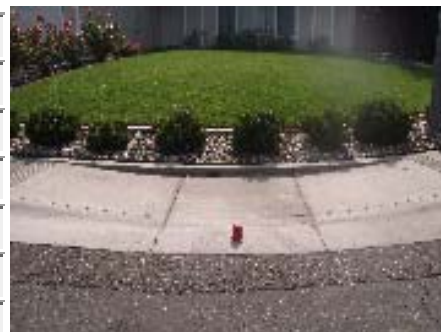
Field Date: ##### Report Date: 10/18/2010 Barrier #: 911B

Barrier Type: Detectable Warnings - Truncated Domes (New Const)

Description: No truncated domes provided at curb ramp

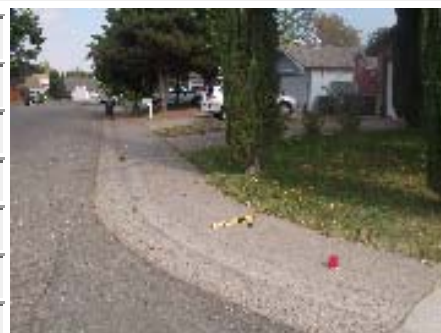
Barrier Type: Cross Slope - Existing (4.1% to 4.9%)

Description: Cross slope exceeds 2.0% (4.1% to 4.9%)

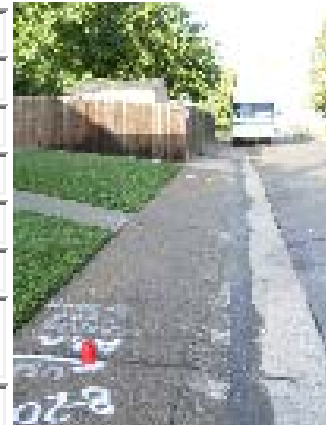
Barrier Type: Cross Slope - Existing (5.0% or more)

Description: Cross slope exceeds 2.0% (5.0% or more)

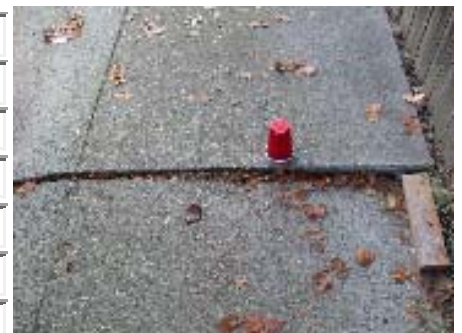
Barrier Type: Abrupt Change in Level - > 1/2"

Description: Change in level greater than 1/2"

Solution: Grind or repair sidewalk to remove trip hazard

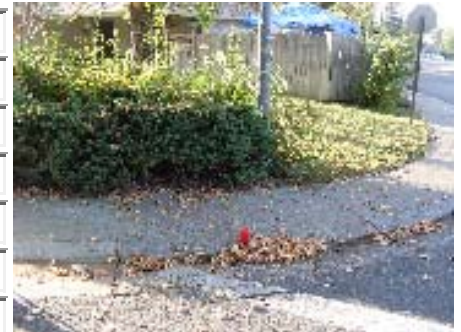
Field Date:	#####	Report Date:	10/18/2010	Barrier #:	914
Location:	Millwood Dr and Glenhurst Wy - Corner C				
X Coordinate:	-121.31739				
Y Coordinate:	38.70488				
Barrier Area:	Curb Ramps				
Barrier Type:	No Curb Ramp - Depressed Exsiting Curb				
Code Ref:	CBC 1127B.5.1 and ADA/ABA 402.2

As Built Meas:	1	Quantity:	EACH
Description:	No compliant curb cut at corner (intersection)		
As Built Desc:	13.1% running slopeat depressed area		
Solution:	Demolish existing and construct curb cut		
Bar. Severity:	1 Necessary	Cost Estimate:	\$2,500.00
Implementation Priority:	4	Facility Function:	
Implementation Phase:		Implementation Date:	
Official Responsible:			
Notes:	Two - way intersection corners C,D

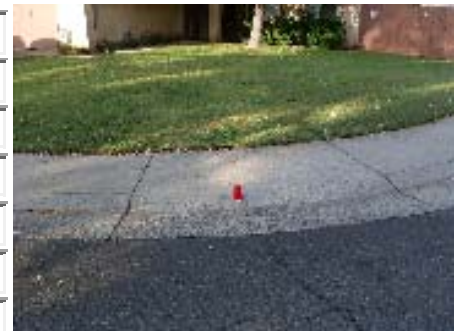
Field Date:	#####	Report Date:	10/18/2010	Barrier #:	915
Location:	Millwood Dr and Glenhurst Wy - Corner D				
X Coordinate:	-121.3176				
Y Coordinate:	38.70499				
Barrier Area:	Curb Ramps				
Barrier Type:	No Curb Ramp - Depressed Exsiting Curb				
Code Ref:	CBC 1127B.5.1 and ADA/ABA 402.2

As Built Meas:	1	Quantity:	EACH
Description:	No compliant curb cut at corner (intersection)		
As Built Desc:	13.4% running slopeat depressed area		
Solution:	Demolish existing and construct curb cut		
Bar. Severity:	1 Necessary	Cost Estimate:	\$2,500.00
Implementation Priority:	4	Facility Function:	
Implementation Phase:		Implementation Date:	
Official Responsible:			
Notes:	Two - way intersection corners C,D

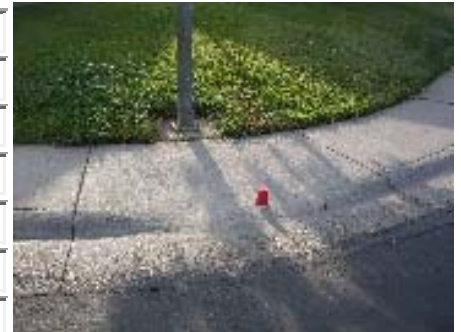
Field Date:	#####	Report Date:	10/18/2010	Barrier #:	918
Location:	Bierston St - South				
X Coordinate:	-121.31962				
Y Coordinate:	38.70333				
Barrier Area:	Sidewalks				
Barrier Type:	Elbow in Sidewalk - Cross Slope (5.0% or more)				
Code Ref:	CBC 1133B.7.1.3 and ADA/ABA 403.3

As Built Meas:	6	Quantity:	LF
Description:	Cross slope at elbow exceeds 2.0% (5.0% or more)		
As Built Desc:	9.3% cross slope		
Solution:	Demolish existing and construct new sidewalk without curb ramp		
Bar. Severity:	1 Necessary	Cost Estimate:	\$750.00
Implementation Priority:	4	Facility Function:	
Implementation Phase:		Implementation Date:	
Official Responsible:			
Notes:

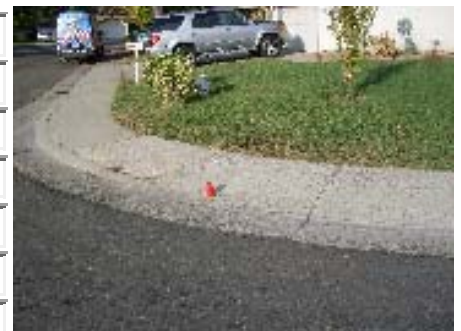
Field Date:	#####	Report Date:	10/18/2010	Barrier #:	919
Location:	Bierston St and Glenhurst Wy - Corner A				
X Coordinate:	-121.31972				
Y Coordinate:	38.70277				
Barrier Area:	Curb Ramps				
Barrier Type:	No Curb Ramp - Depressed Existing Curb				
Code Ref:	CBC 1127B.5.1 and ADA/ABA 402.2

As Built Meas:	1	Quantity:	EACH
Description:	No compliant curb cut at corner (intersection)		
As Built Desc:	11.8% running slope at depressed area		
Solution:	Demolish existing and construct curb cut		
Bar. Severity:	1 Necessary	Cost Estimate:	\$2,500.00
Implementation Priority:	4	Facility Function:	
Implementation Phase:		Implementation Date:	
Official Responsible:			
Notes:	Two - way intersection corners A,B

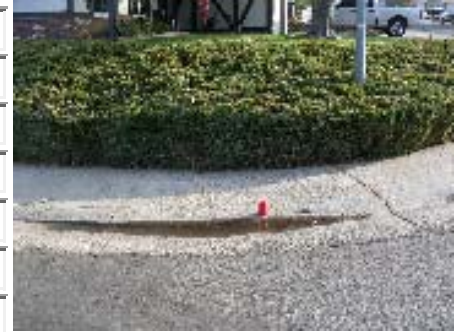
Field Date: ##### Report Date: 10/18/2010 Barrier #: 920

Barrier Type: No Curb Ramp - Depressed Exsiting Curb

Description: No compliant curb cut at corner (intersection)

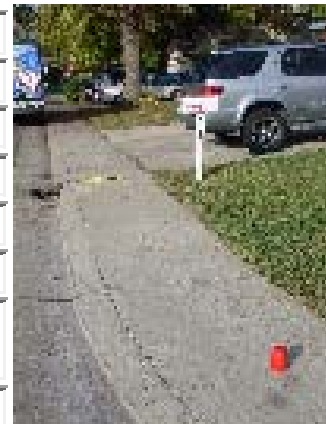
Barrier Type: Cross Slope - Existing (4.1% to 4.9%)

Description: Cross slope exceeds 2.0% (4.1% to 4.9%)

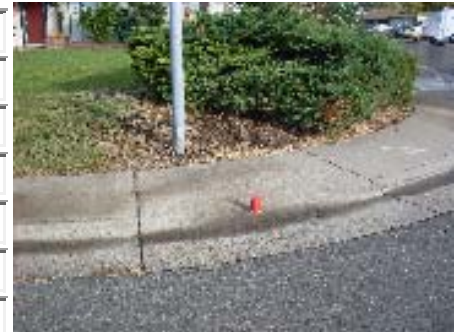
Field Date:	#####	Report Date:	10/18/2010	Barrier #:	922
Location:	Pinecreek Ct and Pinecreek Wy - Corner A				
X Coordinate:	-121.31954				
Y Coordinate:	38.70467				
Barrier Area:	Curb Ramps				
Barrier Type:	No Curb Ramp - Depressed Exsiting Curb				
Code Ref:	CBC 1127B.5.1 and ADA/ABA 402.2

As Built Meas:	1	Quantity:	EACH
Description:	No compliant curb cut at corner (intersection)		
As Built Desc:	12.3% running slope at depressed area		
Solution:	Demolish existing and construct curb cut		
Bar. Severity:	1 Necessary	Cost Estimate:	\$2,500.00
Implementation Priority:	4	Facility Function:	
Implementation Phase:		Implementation Date:	
Official Responsible:			
Notes:	Two - way intersection corners A,D

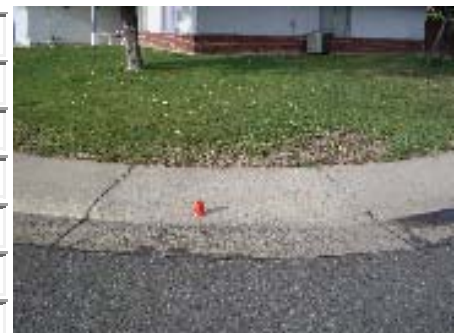
Field Date:	#####	Report Date:	10/18/2010	Barrier #:	923
Location:	Pinecreek Ct and Pinecreek Wy - Corner D				
X Coordinate:	-121.31956				
Y Coordinate:	38.70457				
Barrier Area:	Curb Ramps				
Barrier Type:	No Curb Ramp - Depressed Exsiting Curb				
Code Ref:	CBC 1127B.5.1 and ADA/ABA 402.2

As Built Meas:	1	Quantity:	EACH
Description:	No compliant curb cut at corner (intersection)		
As Built Desc:	13.7% running slope at depressed area		
Solution:	Demolish existing and construct curb cut		
Bar. Severity:	1 Necessary	Cost Estimate:	\$2,500.00
Implementation Priority:	4	Facility Function:	
Implementation Phase:		Implementation Date:	
Official Responsible:			
Notes:	Two - way intersection corners A,D

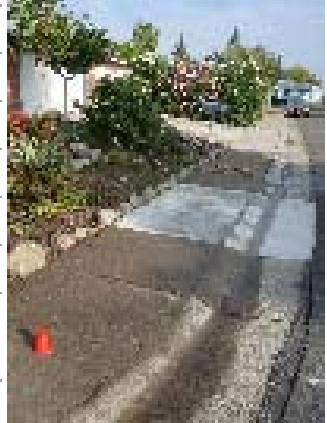
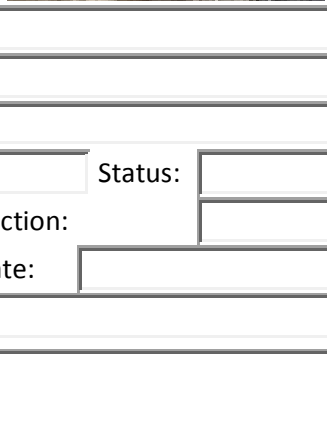
Field Date:	#####	Report Date:	10/18/2010	Barrier #:	924

Location:	Pinecreek Wy - West					
X Coordinate:	-121.31951					
Y Coordinate:	38.70474					
Barrier Area:	Sidewalks					
Barrier Type:	Cross Slope - Existing (4.1% to 4.9%)					
Code Ref:	CBC 1133B.7.1.3 and ADA/ABA 403.3					
As Built Meas:	213		Quantity:	LF

Description:	Cross slope exceeds 2.0% (4.1% to 4.9%)					
As Built Desc:	4.7% cross slope					
Solution:	Demolish existing and construct new route					
Bar. Severity:	2 Recommended		Cost Estimate:	\$26,625.00	Status:	
Implementation Priority:	4		Facility Function:			
Implementation Phase:			Implementation Date:			
Official Responsible:						
Notes:

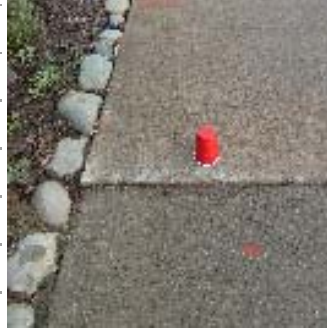
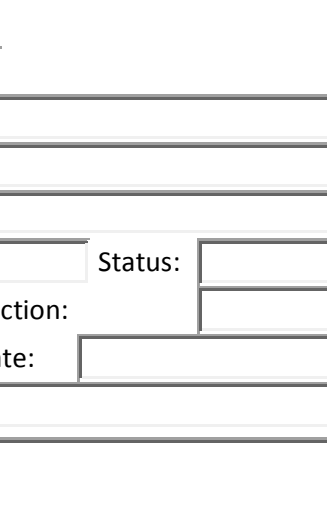
Field Date:	#####	Report Date:	10/18/2010	Barrier #:	925

Location:	Pinecreek Wy - West					
X Coordinate:	-121.31949					
Y Coordinate:	38.70479					
Barrier Area:	Sidewalks					
Barrier Type:	Abrupt Change in Level - > 1/2"					
Code Ref:	CBC 1133B.7.1 and ADA/ABA 303.3					
As Built Meas:	4		Quantity:	LF

Description:	Change in level greater than 1/2"					
As Built Desc:	1" lip in sidewalk surface					
Solution:	Grind or repair sidewalk to remove trip hazard					
Bar. Severity:	1 Necessary		Cost Estimate:	\$1,000.00	Status:	
Implementation Priority:	4		Facility Function:			
Implementation Phase:			Implementation Date:			
Official Responsible:						
Notes:

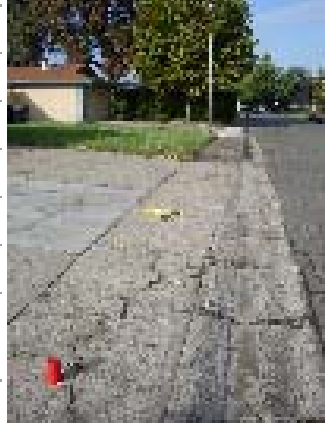
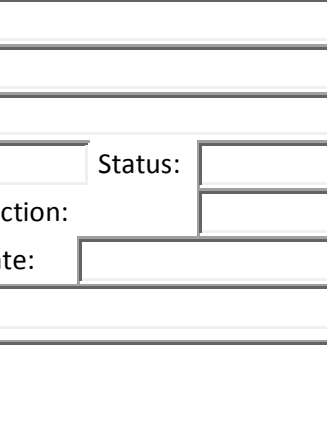
Field Date:	#####	Report Date:	10/18/2010	Barrier #:	926

Location:	Pinecreek Wy - South					
X Coordinate:	-121.31976					
Y Coordinate:	38.70537					
Barrier Area:	Sidewalks					
Barrier Type:	Cross Slope - Existing (5.0% or more)					
Code Ref:	CBC 1133B.7.1.3 and ADA/ABA 403.3					
As Built Meas:	313		Quantity:	LF

Description:	Cross slope exceeds 2.0% (5.0% or more)					
As Built Desc:	10.8% cross slope					
Solution:	Demolish existing and construct new route					
Bar. Severity:	1 Necessary		Cost Estimate:	\$39,125.00	Status:	
Implementation Priority:	4		Facility Function:			
Implementation Phase:			Implementation Date:			
Official Responsible:						
Notes:

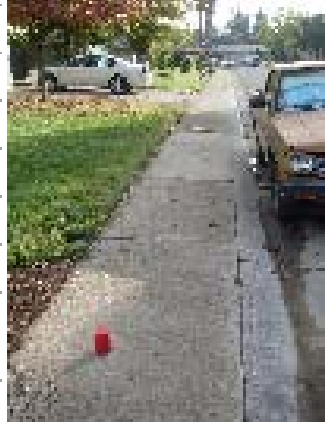
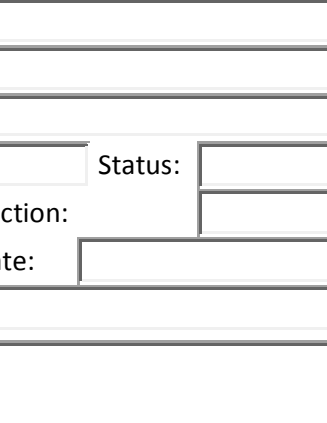
Field Date:	#####	Report Date:	10/18/2010	Barrier #:	927

Location:	Pinecreek Wy - North					
X Coordinate:	-121.32037					
Y Coordinate:	38.70549					
Barrier Area:	Sidewalks					
Barrier Type:	Cross Slope - Existing (5.0% or more)					
Code Ref:	CBC 1133B.7.1.3 and ADA/ABA 403.3					
As Built Meas:	283		Quantity:	LF

Description:	Cross slope exceeds 2.0% (5.0% or more)					
As Built Desc:	6.4% cross slope					
Solution:	Demolish existing and construct new route					
Bar. Severity:	1 Necessary		Cost Estimate:	\$35,375.00	Status:	
Implementation Priority:	4		Facility Function:			
Implementation Phase:			Implementation Date:			
Official Responsible:						
Notes:

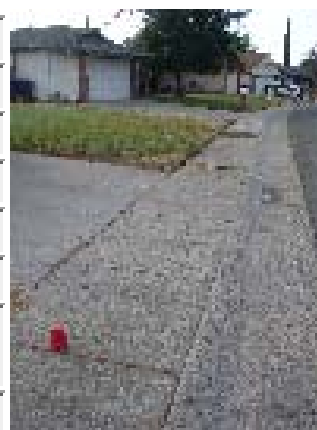
Barrier Type: Cross Slope - Existing (4.1% to 4.9%)

Description: Cross slope exceeds 2.0% (4.1% to 4.9%)

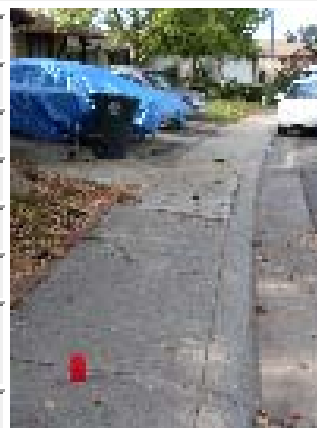
Barrier Type: Cross Slope - Existing (5.0% or more)

Description: Cross slope exceeds 2.0% (5.0% or more)

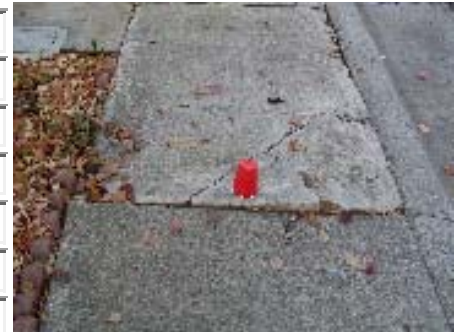
Field Date:	#####	Report Date:	10/18/2010	Barrier #:	929B
Location:	Pinecreek Wy - East				
X Coordinate:	-121.3198				
Y Coordinate:	38.70408				
Barrier Area:	Sidewalks				
Barrier Type:	Abrupt Change in Level - > 1/2"				
Code Ref:	CBC 1133B.7.1 and ADA/ABA 303.3

As Built Meas:	4	Quantity:	LF
Description:	Change in level greater than 1/2"		
As Built Desc:	1" lip in sidewalk surface		
Solution:	Grind or repair sidewalk to remove trip hazard		
Bar. Severity:	1 Necessary	Cost Estimate:	\$1,000.00
Implementation Priority:	4	Facility Function:	
Implementation Phase:		Implementation Date:	
Official Responsible:			
Notes:

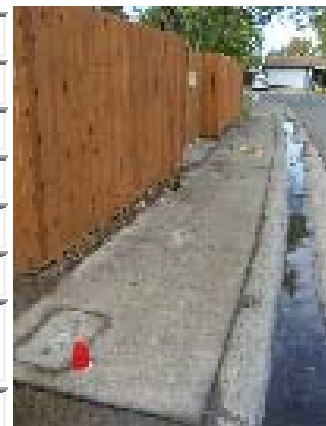
Field Date:	#####	Report Date:	10/18/2010	Barrier #:	930
Location:	Pinecreek Wy - South				
X Coordinate:	-121.32035				
Y Coordinate:	38.70385				
Barrier Area:	Sidewalks				
Barrier Type:	Cross Slope - Existing (5.0% or more)				
Code Ref:	CBC 1133B.7.1.3 and ADA/ABA 403.3

As Built Meas:	92	Quantity:	LF
Description:	Cross slope exceeds 2.0% (5.0% or more)		
As Built Desc:	6.7% cross slope		
Solution:	Demolish existing and construct new route		
Bar. Severity:	1 Necessary	Cost Estimate:	\$11,500.00
Implementation Priority:	4	Facility Function:	
Implementation Phase:		Implementation Date:	
Official Responsible:			
Notes:

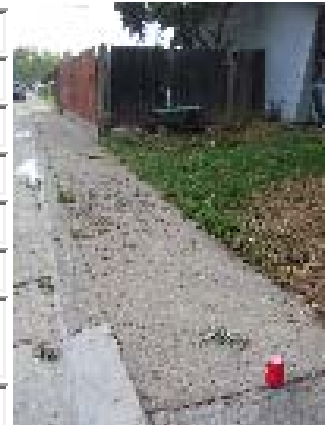
Field Date:	#####	Report Date:	10/18/2010	Barrier #:	931A
Location:	Rumford Ave - South				
X Coordinate:	-121.32073				
Y Coordinate:	38.70609				
Barrier Area:	Sidewalks				
Barrier Type:	Cross Slope - Existing (5.0% or more)				
Code Ref:	CBC 1133B.7.1.3 and ADA/ABA 403.3

As Built Meas:	711	Quantity:	LF		
Description:	Cross slope exceeds 2.0% (5.0% or more)				
As Built Desc:	7.2% cross slope				
Solution:	Demolish existing and construct new route				
Bar. Severity:	1 Necessary	Cost Estimate:	\$88,875.00	Status:	
Implementation Priority:	4	Facility Function:			
Implementation Phase:		Implementation Date:			
Official Responsible:					
Notes:

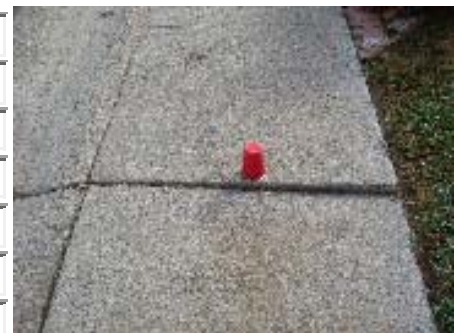
Field Date:	#####	Report Date:	10/18/2010	Barrier #:	931B
Location:	Rumford Ave - South				
X Coordinate:	-121.3194				
Y Coordinate:	38.70609				
Barrier Area:	Sidewalks				
Barrier Type:	Abrupt Change in Level - > 1/2"				
Code Ref:	CBC 1133B.7.1 and ADA/ABA 303.3

As Built Meas:	4	Quantity:	LF		
Description:	Change in level greater than 1/2"				
As Built Desc:	1" lip in sidewalk surface				
Solution:	Grind or repair sidewalk to remove trip hazard				
Bar. Severity:	1 Necessary	Cost Estimate:	\$1,000.00	Status:	
Implementation Priority:	4	Facility Function:			
Implementation Phase:		Implementation Date:			
Official Responsible:					
Notes:

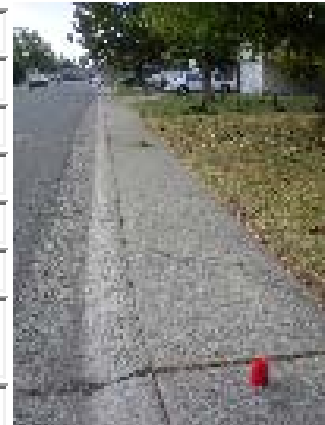
Barrier Type: Cross Slope - Existing (5.0% or more)

Description: Cross slope exceeds 2.0% (5.0% or more)

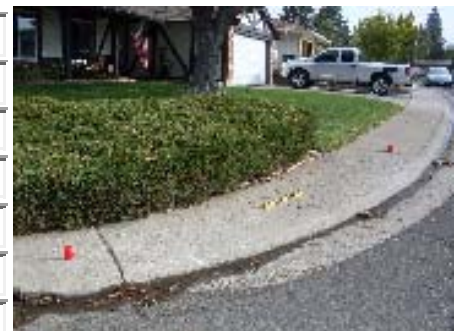
Barrier Type: Running Slope (Existing)

Description: Running slope exceeds 5.0%

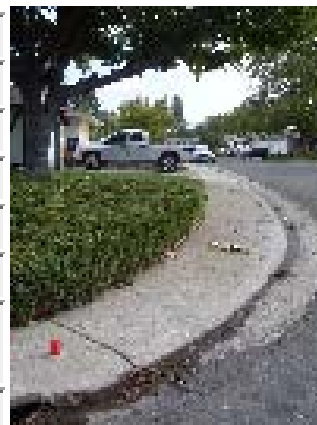
Barrier Type: Cross Slope - Existing (4.1% to 4.9%)

Description: Cross slope exceeds 2.0% (4.1% to 4.9%)

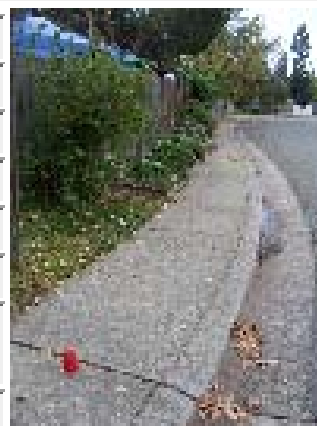
Barrier Type: Cross Slope - Existing (5.0% or more)

Description: Cross slope exceeds 2.0% (5.0% or more)

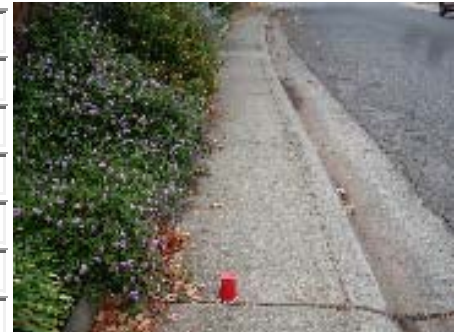
Field Date:	#####	Report Date:	10/18/2010	Barrier #:	934B
Location:	Glenhurst Wy - East				
X Coordinate:	-121.31759				
Y Coordinate:	38.70481				
Barrier Area:	Sidewalks				
Barrier Type:	Clear Width - Existing (32" to 35")				
Code Ref:	CBC 1133B.7.1

As Built Meas:	1	Quantity:	LF
Description:	Pedestrian route is not min. 48" wide (32" to 35")		
As Built Desc:	32" clear width due to foliage		
Solution:	Trim foliage to provide min. 48" clear width		
Bar. Severity:	2 Recommended	Cost Estimate:	\$125.00
Implementation Priority:	4	Facility Function:	
Implementation Phase:		Implementation Date:	
Official Responsible:

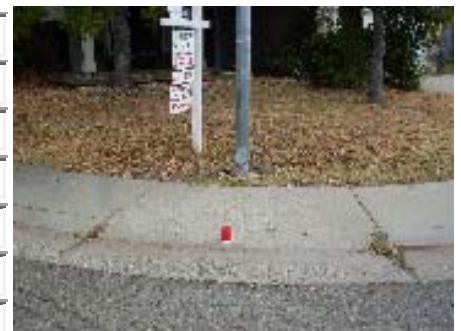
Field Date:	#####	Report Date:	10/18/2010	Barrier #:	935
Location:	Stoneridge Wy and Glenhurst Wy - Corner B				
X Coordinate:	-121.31762				
Y Coordinate:	38.70438				
Barrier Area:	Curb Ramps				
Barrier Type:	No Curb Ramp - Depressed Existing Curb				
Code Ref:	CBC 1127B.5.1 and ADA/ABA 402.2

As Built Meas:	1	Quantity:	EACH
Description:	No compliant curb cut at corner (intersection)		
As Built Desc:	12.7% running slope at depressed area		
Solution:	Demolish existing and construct curb cut		
Bar. Severity:	1 Necessary	Cost Estimate:	\$2,500.00
Implementation Priority:	4	Facility Function:	
Implementation Phase:		Implementation Date:	
Official Responsible:

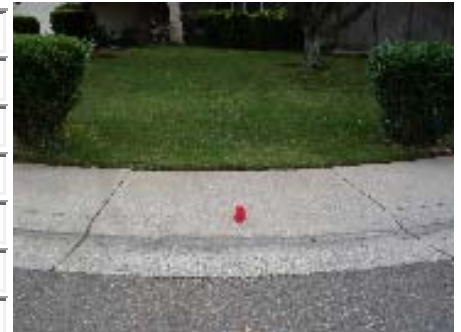
Field Date:	#####	Report Date:	10/18/2010	Barrier #:	936
Location:	Stoneridge Wy and Glenhurst Wy - Corner C				
X Coordinate:	-121.31765				
Y Coordinate:	38.70425				
Barrier Area:	Curb Ramps				
Barrier Type:	No Curb Ramp - Depressed Exsiting Curb				
Code Ref:	CBC 1127B.5.1 and ADA/ABA 402.2

As Built Meas:	1	Quantity:	EACH
Description:	No compliant curb cut at corner (intersection)		
As Built Desc:	10.3% running slope at depressed area		
Solution:	Demolish existing and construct curb cut		
Bar. Severity:	1 Necessary	Cost Estimate:	\$2,500.00
Implementation Priority:	4	Facility Function:	
Implementation Phase:		Implementation Date:	
Official Responsible:			
Notes:	Two - way intersection corners B,C

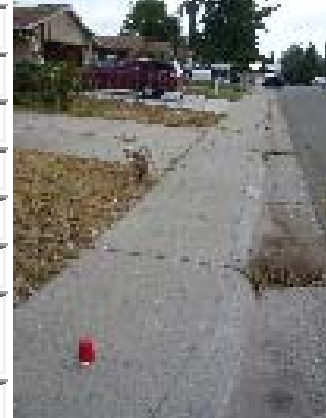
Field Date:	#####	Report Date:	10/18/2010	Barrier #:	937
Location:	Stoneridge Wy - North				
X Coordinate:	-121.31754				
Y Coordinate:	38.70427				
Barrier Area:	Sidewalks				
Barrier Type:	Cross Slope - Existing (4.1% to 4.9%)				
Code Ref:	CBC 1133B.7.1.3 and ADA/ABA 403.3

As Built Meas:	335	Quantity:	LF
Description:	Cross slope exceeds 2.0% (4.1% to 4.9%)		
As Built Desc:	4.6% cross slope		
Solution:	Demolish existing and construct new route		
Bar. Severity:	2 Recommended	Cost Estimate:	\$41,875.00
Implementation Priority:	4	Facility Function:	
Implementation Phase:		Implementation Date:	
Official Responsible:			
Notes:

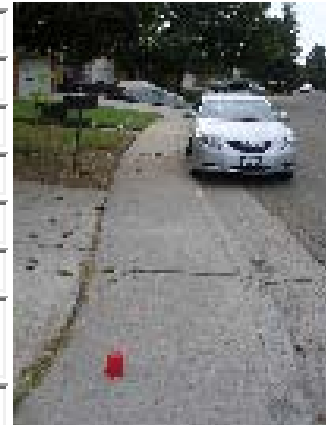
Field Date:	#####	Report Date:	10/18/2010	Barrier #:	938
Location:	Stoneridge Wy - East				
X Coordinate:	-121.31645				
Y Coordinate:	38.70373				
Barrier Area:	Sidewalks				
Barrier Type:	Cross Slope - Existing (4.1% to 4.9%)				
Code Ref:	CBC 1133B.7.1.3 and ADA/ABA 403.3				
As Built Meas:	463	Quantity:	LF		
Description:	Cross slope exceeds 2.0% (4.1% to 4.9%)				
As Built Desc:	4.6% cross slope				
Solution:	Demolish existing and construct new route				
Bar. Severity:	2 Recommended	Cost Estimate:	\$57,875.00	Status:	
Implementation Priority:	4	Facility Function:			
Implementation Phase:		Implementation Date:			
Official Responsible:					
Notes:

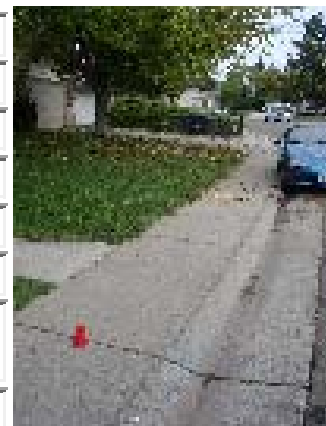
Field Date:	#####	Report Date:	10/18/2010	Barrier #:	939A
Location:	Stoneridge Wy - West				
X Coordinate:	-121.3166				
Y Coordinate:	38.70326				
Barrier Area:	Sidewalks				
Barrier Type:	Cross Slope - Existing (5.0% or more)				
Code Ref:	CBC 1133B.7.1.3 and ADA/ABA 403.3				
As Built Meas:	1215	Quantity:	LF		
Description:	Cross slope exceeds 2.0% (5.0% or more)				
As Built Desc:	7.3% cross slope				
Solution:	Demolish existing and construct new route				
Bar. Severity:	1 Necessary	Cost Estimate:	\$151,875.00	Status:	
Implementation Priority:	4	Facility Function:			
Implementation Phase:		Implementation Date:			
Official Responsible:					
Notes:

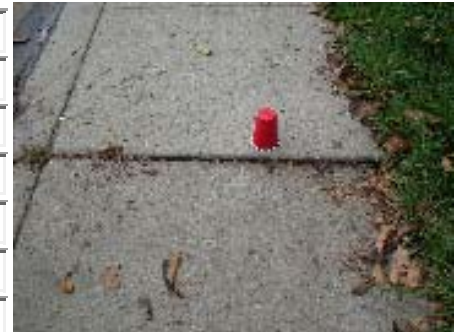
Field Date:	#####	Report Date:	10/18/2010	Barrier #:	939B
Location:	Stoneridge Wy - West				
X Coordinate:	-121.3166				
Y Coordinate:	38.70324				
Barrier Area:	Sidewalks				
Barrier Type:	Abrupt Change in Level - > 1/2"				
Code Ref:	CBC 1133B.7.1 and ADA/ABA 303.3

As Built Meas:	4	Quantity:	LF
Description:	Change in level greater than 1/2"		
As Built Desc:	1" lip in sidewalk surface		
Solution:	Grind or repair sidewalk to remove trip hazard		
Bar. Severity:	1 Necessary	Cost Estimate:	\$1,000.00
Implementation Priority:	4	Facility Function:	
Implementation Phase:		Implementation Date:	
Official Responsible:			
Notes:

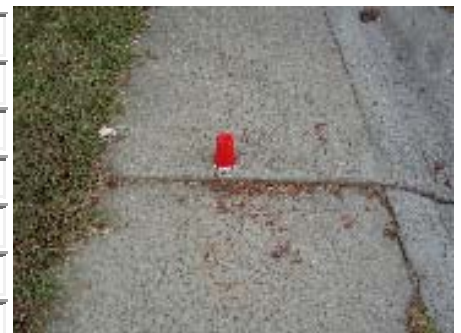
Field Date:	#####	Report Date:	10/18/2010	Barrier #:	939C
Location:	Stoneridge Wy - West				
X Coordinate:	-121.31652				
Y Coordinate:	38.70364				
Barrier Area:	Sidewalks				
Barrier Type:	Abrupt Change in Level - > 1/2"				
Code Ref:	CBC 1133B.7.1 and ADA/ABA 303.3

As Built Meas:	4	Quantity:	LF
Description:	Change in level greater than 1/2"		
As Built Desc:	1" lip in sidewalk surface		
Solution:	Grind or repair sidewalk to remove trip hazard		
Bar. Severity:	1 Necessary	Cost Estimate:	\$1,000.00
Implementation Priority:	4	Facility Function:	
Implementation Phase:		Implementation Date:	
Official Responsible:			
Notes:

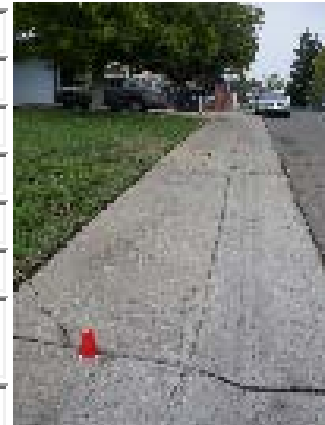
Barrier Type: Cross Slope - Existing (4.1% to 4.9%)

Description: Cross slope exceeds 2.0% (4.1% to 4.9%)

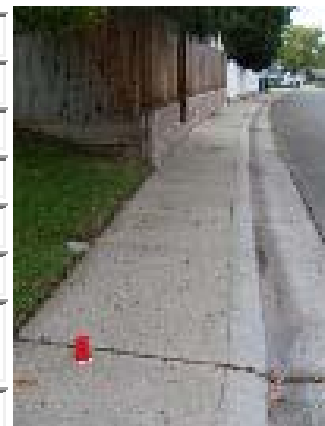
Barrier Type: Cross Slope - Existing (4.1% to 4.9%)

Description: Cross slope exceeds 2.0% (4.1% to 4.9%)

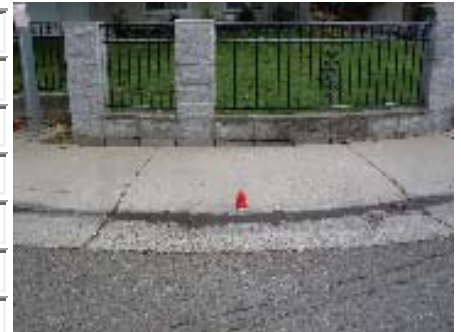
Field Date:	#####	Report Date:	10/18/2010	Barrier #:	942
Location:	Glenhurst Wy and Mar Vista Wy - Corner B				
X Coordinate:	-121.31791				
Y Coordinate:	38.70375				
Barrier Area:	Curb Ramps				
Barrier Type:	No Curb Ramp - Depressed Exsiting Curb				
Code Ref:	CBC 1127B.5.1 and ADA/ABA 402.2

As Built Meas:	1	Quantity:	EACH
Description:	No compliant curb cut at corner (intersection)		
As Built Desc:	12.5% running slope at depressed area		
Solution:	Demolish existing and construct curb cut		
Bar. Severity:	1 Necessary	Cost Estimate:	\$2,500.00
Implementation Priority:	4	Facility Function:	
Implementation Phase:		Implementation Date:	
Official Responsible:			
Notes:	Two - way intersection corners B,C GPS 036

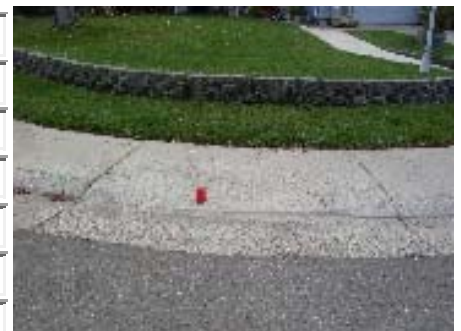
Field Date:	#####	Report Date:	10/18/2010	Barrier #:	943
Location:	Glenhurst Wy and Mar Vista Wy - Corner C				
X Coordinate:	-121.31801				
Y Coordinate:	38.70367				
Barrier Area:	Curb Ramps				
Barrier Type:	No Curb Ramp - Depressed Exsiting Curb				
Code Ref:	CBC 1127B.5.1 and ADA/ABA 402.2

As Built Meas:	1	Quantity:	EACH
Description:	No compliant curb cut at corner (intersection)		
As Built Desc:	13.7% running slope at depressed area		
Solution:	Demolish existing and construct curb cut		
Bar. Severity:	1 Necessary	Cost Estimate:	\$2,500.00
Implementation Priority:	4	Facility Function:	
Implementation Phase:		Implementation Date:	
Official Responsible:			
Notes:	Two - way intersection corners B,C GPS 037

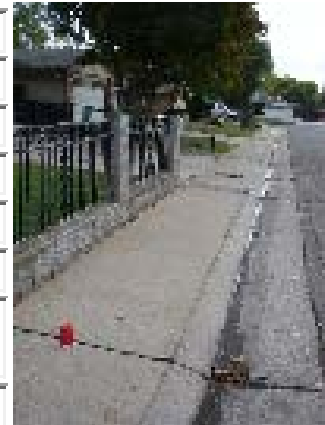
Field Date:	#####	Report Date:	10/18/2010	Barrier #:	944
Location:	Mar Vista Wy - North				
X Coordinate:	-121.31787				
Y Coordinate:	38.70366				
Barrier Area:	Sidewalks				
Barrier Type:	Cross Slope - Existing (4.1% to 4.9%)				
Code Ref:	CBC 1133B.7.1.3 and ADA/ABA 403.3

As Built Meas:	214	Quantity:	LF
Description:	Cross slope exceeds 2.0% (4.1% to 4.9%)		
As Built Desc:	4.2% cross slope		
Solution:	Demolish existing and construct new route		
Bar. Severity:	2 Recommended	Cost Estimate:	\$26,750.00
Implementation Priority:	4	Facility Function:	
Implementation Phase:		Implementation Date:	
Official Responsible:			
Notes:

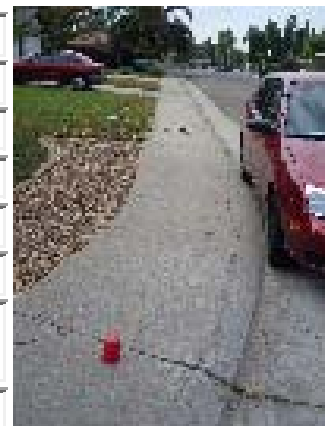
Field Date:	#####	Report Date:	10/18/2010	Barrier #:	945
Location:	Mar Vista Wy - East				
X Coordinate:	-121.31741				
Y Coordinate:	38.70318				
Barrier Area:	Sidewalks				
Barrier Type:	Cross Slope - Existing (5.0% or more)				
Code Ref:	CBC 1133B.7.1.3 and ADA/ABA 403.3

As Built Meas:	224	Quantity:	LF
Description:	Cross slope exceeds 2.0% (5.0% or more)		
As Built Desc:	6.3% cross slope		
Solution:	Demolish existing and construct new route		
Bar. Severity:	1 Necessary	Cost Estimate:	\$28,000.00
Implementation Priority:	4	Facility Function:	
Implementation Phase:		Implementation Date:	
Official Responsible:			
Notes:

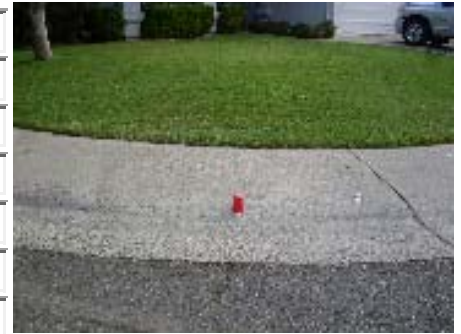
Field Date:	#####	Report Date:	10/18/2010	Barrier #:	946
Location:	Mar Vista Wy and Wild Oak Dr - Corner B				
X Coordinate:	-121.3179				
Y Coordinate:	38.70268				
Barrier Area:	Curb Ramps				
Barrier Type:	No Curb Ramp - Depressed Exsiting Curb				
Code Ref:	CBC 1127B.5.1 and ADA/ABA 402.2

As Built Meas:	1	Quantity:	EACH
Description:	No compliant curb cut at corner (intersection)		
As Built Desc:	11.3% running slope at depressed area		
Solution:	Demolish existing and construct curb cut		
Bar. Severity:	1 Necessary	Cost Estimate:	\$2,500.00
Implementation Priority:	4	Facility Function:	
Implementation Phase:		Implementation Date:	
Official Responsible:			
Notes:	Two - way intersection corners B,C

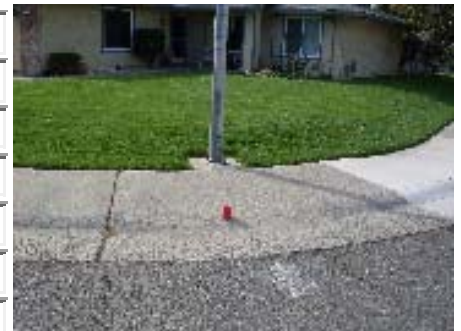
Field Date:	#####	Report Date:	10/18/2010	Barrier #:	947
Location:	Mar Vista Wy and Wild Oak Dr - Corner C				
X Coordinate:	-121.31803				
Y Coordinate:	38.70257				
Barrier Area:	Curb Ramps				
Barrier Type:	No Curb Ramp - Depressed Exsiting Curb				
Code Ref:	CBC 1127B.5.1 and ADA/ABA 402.2

As Built Meas:	1	Quantity:	EACH
Description:	No compliant curb cut at corner (intersection)		
As Built Desc:	9.3% running slope at depressed area		
Solution:	Demolish existing and construct curb cut		
Bar. Severity:	1 Necessary	Cost Estimate:	\$2,500.00
Implementation Priority:	4	Facility Function:	
Implementation Phase:		Implementation Date:	
Official Responsible:			
Notes:	Two - way intersection corners B,C

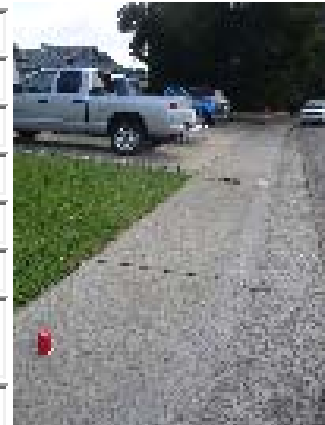
Field Date:	#####	Report Date:	10/18/2010	Barrier #:	948
Location:	Wild Oak Dr - West				
X Coordinate:	-121.31788				
Y Coordinate:	38.70265				
Barrier Area:	Sidewalks				
Barrier Type:	Cross Slope - Existing (5.0% or more)				
Code Ref:	CBC 1133B.7.1.3 and ADA/ABA 403.3

As Built Meas:	362	Quantity:	LF
Description:	Cross slope exceeds 2.0% (5.0% or more)		
As Built Desc:	6.3% cross slope		
Solution:	Demolish existing and construct new route		
Bar. Severity:	1 Necessary	Cost Estimate:	\$45,250.00
Implementation Priority:	4	Facility Function:	
Implementation Phase:		Implementation Date:	
Official Responsible:			
Notes:

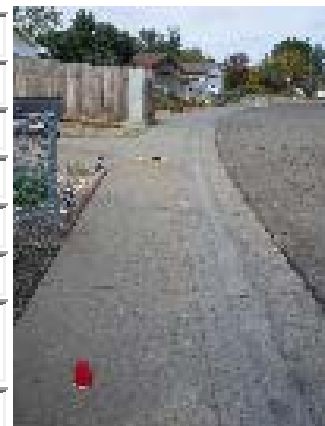
Field Date:	#####	Report Date:	10/18/2010	Barrier #:	949
Location:	Wild Oak Dr - East				
X Coordinate:	-121.31733				
Y Coordinate:	38.70185				
Barrier Area:	Sidewalks				
Barrier Type:	Cross Slope - Existing (5.0% or more)				
Code Ref:	CBC 1133B.7.1.3 and ADA/ABA 403.3

As Built Meas:	354	Quantity:	LF
Description:	Cross slope exceeds 2.0% (5.0% or more)		
As Built Desc:	5.7% cross slope		
Solution:	Demolish existing and construct new route		
Bar. Severity:	1 Necessary	Cost Estimate:	\$44,250.00
Implementation Priority:	4	Facility Function:	
Implementation Phase:		Implementation Date:	
Official Responsible:			
Notes:

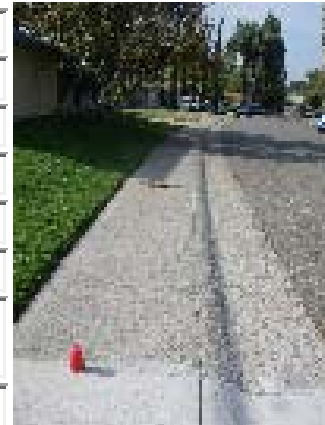
Barrier Type: Cross Slope - Existing (5.0% or more)

As Built Meas: 401 Quantity: LF

Description: Cross slope exceeds 2.0% (5.0% or more)

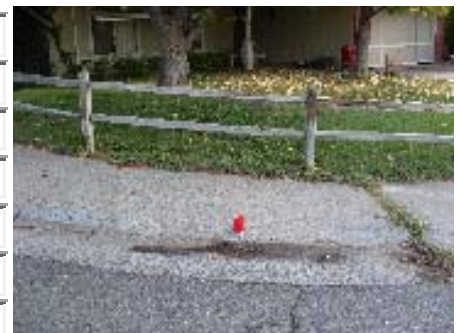
Barrier Type: Elbow in Sidewalk - Cross Slope (5.0% or more)

As Built Meas: 6 Quantity: LF

Description: Cross slope at elbow exceeds 2.0% (5.0% or more)

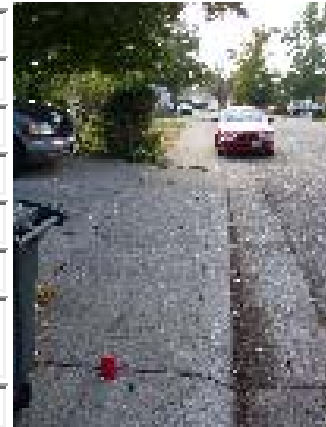
Field Date:	#####	Report Date:	10/18/2010	Barrier #:	952
Location:	Mar Vista Wy - East				
X Coordinate:	-121.31931				
Y Coordinate:	38.70184				
Barrier Area:	Sidewalks				
Barrier Type:	Cross Slope - Existing (5.0% or more)				
Code Ref:	CBC 1133B.7.1.3 and ADA/ABA 403.3				
As Built Meas:	242	Quantity:	LF		
Description:	Cross slope exceeds 2.0% (5.0% or more)				
As Built Desc:	6.3% cross slope				
Solution:	Demolish existing and construct new route				
Bar. Severity:	1 Necessary	Cost Estimate:	\$30,250.00	Status:	
Implementation Priority:	4	Facility Function:			
Implementation Phase:		Implementation Date:			
Official Responsible:					
Notes:

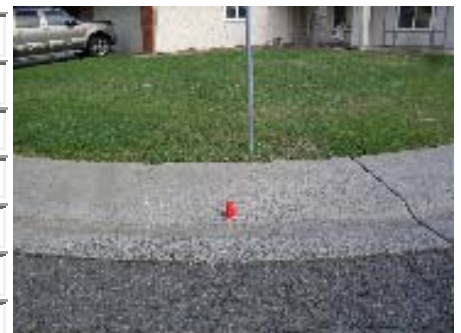
Field Date:	#####	Report Date:	10/18/2010	Barrier #:	953
Location:	Mar Vista Wy and Sky Vista Ct - Corner B				
X Coordinate:	-121.31891				
Y Coordinate:	38.70115				
Barrier Area:	Curb Ramps				
Barrier Type:	No Curb Ramp - Depressed Existing Curb				
Code Ref:	CBC 1127B.5.1 and ADA/ABA 402.2				
As Built Meas:	1	Quantity:	EACH		
Description:	No compliant curb cut at corner (intersection)				
As Built Desc:	14.4% running slope at depressed area				
Solution:	Demolish existing and construct curb cut				
Bar. Severity:	1 Necessary	Cost Estimate:	\$2,500.00	Status:	
Implementation Priority:	4	Facility Function:			
Implementation Phase:		Implementation Date:			
Official Responsible:					
Notes:	Two - way intersection corners B,C

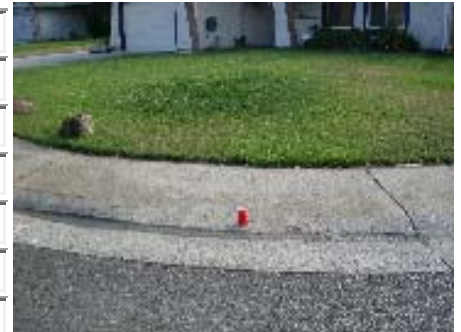
Field Date:	#####	Report Date:	10/18/2010	Barrier #:	954
Location:	Mar Vista Wy and Sky Vista Ct - Corner C				
X Coordinate:	-121.31883				
Y Coordinate:	38.70108				
Barrier Area:	Curb Ramps				
Barrier Type:	No Curb Ramp - Depressed Exsiting Curb				
Code Ref:	CBC 1127B.5.1 and ADA/ABA 402.2

As Built Meas:	1	Quantity:	EACH
Description:	No compliant curb cut at corner (intersection)		
As Built Desc:	10.1% running slope at depressed area		
Solution:	Demolish existing and construct curb cut		
Bar. Severity:	1 Necessary	Cost Estimate:	\$2,500.00
Implementation Priority:	4	Facility Function:	
Implementation Phase:		Implementation Date:	
Official Responsible:			
Notes:	Two - way intersection corners B,C

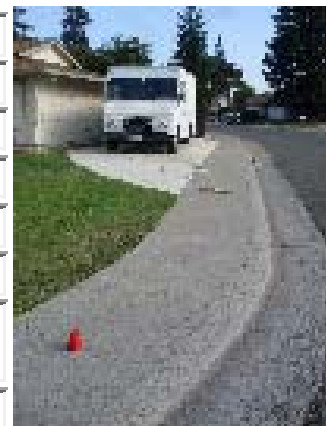
Field Date:	#####	Report Date:	10/18/2010	Barrier #:	955
Location:	Sky Vista - North				
X Coordinate:	-121.31885				
Y Coordinate:	38.7012				
Barrier Area:	Sidewalks				
Barrier Type:	Cross Slope - Existing (5.0% or more)				
Code Ref:	CBC 1133B.7.1.3 and ADA/ABA 403.3

As Built Meas:	299	Quantity:	LF
Description:	Cross slope exceeds 2.0% (5.0% or more)		
As Built Desc:	5.5% cross slope		
Solution:	Demolish existing and construct new route		
Bar. Severity:	1 Necessary	Cost Estimate:	\$37,375.00
Implementation Priority:	4	Facility Function:	
Implementation Phase:		Implementation Date:	
Official Responsible:			
Notes:

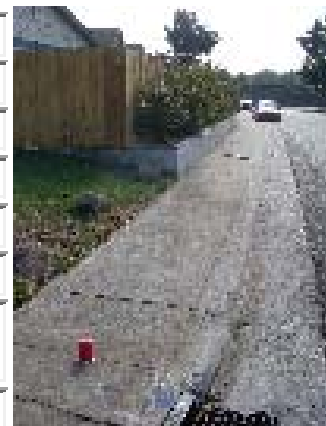
Field Date:	#####	Report Date:	10/18/2010	Barrier #:	958
Location:	Mar Vista Wy- West				
X Coordinate:	-121.31849				
Y Coordinate:	38.70053				
Barrier Area:	Sidewalks				
Barrier Type:	Cross Slope - Existing (4.1% to 4.9%)				
Code Ref:	CBC 1133B.7.1.3 and ADA/ABA 403.3				
As Built Meas:	625	Quantity:	LF		
Description:	Cross slope exceeds 2.0% (4.1% to 4.9%)				
As Built Desc:	4.3% cross slope				
Solution:	Demolish existing and construct new route				
Bar. Severity:	2 Recommended	Cost Estimate:	\$78,125.00	Status:	
Implementation Priority:	4	Facility Function:			
Implementation Phase:		Implementation Date:			
Official Responsible:					
Notes:

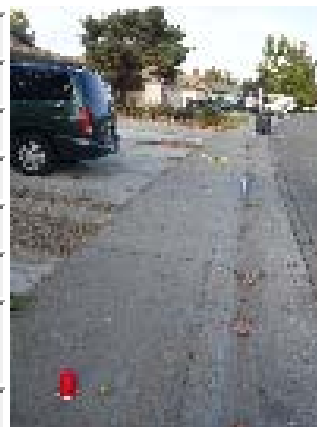
Field Date:	#####	Report Date:	10/18/2010	Barrier #:	959
Location:	Mar Vista Wy- North				
X Coordinate:	-121.31947				
Y Coordinate:	38.702				
Barrier Area:	Sidewalks				
Barrier Type:	Cross Slope - Existing (5.0% or more)				
Code Ref:	CBC 1133B.7.1.3 and ADA/ABA 403.3				
As Built Meas:	776	Quantity:	LF		
Description:	Cross slope exceeds 2.0% (5.0% or more)				
As Built Desc:	7.1% cross slope				
Solution:	Demolish existing and construct new route				
Bar. Severity:	1 Necessary	Cost Estimate:	\$97,000.00	Status:	
Implementation Priority:	4	Facility Function:			
Implementation Phase:		Implementation Date:			
Official Responsible:					
Notes:

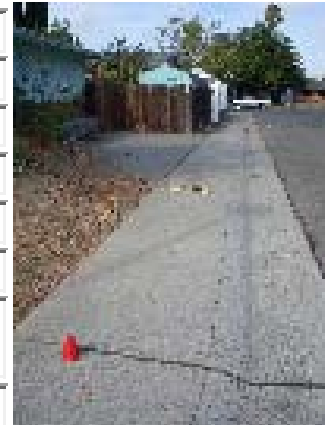
Barrier Type: Cross Slope - Existing (5.0% or more)

As Built Meas: 124 Quantity: LF

Description: Cross slope exceeds 2.0% (5.0% or more)

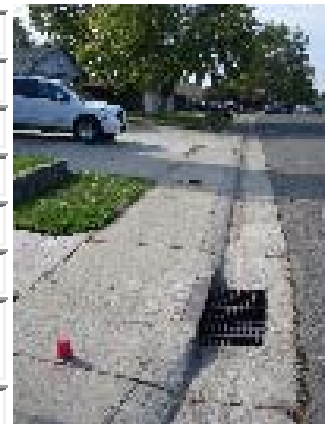
Barrier Type: Cross Slope - Existing (5.0% or more)

As Built Meas: 769 Quantity: LF

Description: Cross slope exceeds 2.0% (5.0% or more)

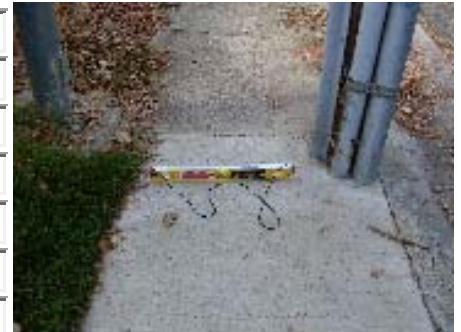
Field Date:	#####	Report Date:	10/18/2010	Barrier #:	961B
Location:	Glenhurst Wy - South				
X Coordinate:	-121.31994				
Y Coordinate:	38.70262				
Barrier Area:	Sidewalks				
Barrier Type:	Clear Width - Existing ($\leq 31"$ or less)				
Code Ref:	CBC 1133B.7.1

As Built Meas:	4	Quantity:	LF
Description:	Pedestrian route is not min. 48" wide ($\leq 31"$ or less)		
As Built Desc:	30" clear width due to pole		
Solution:	Make alterations to provide min. 32" clear width		
Bar. Severity:	1 Necessary	Cost Estimate:	\$500.00
Implementation Priority:	4	Facility Function:	
Implementation Phase:		Implementation Date:	
Official Responsible:			
Notes:
