DRAFT ADA TRANSITION PLAN UPDATE
NEIGHBORHOOD AREA 1 NORTHWEST
SEPTEMBER 20, 2011

CITY OF CITRUS HEIGHTS

The Northwest Neighborhood Association

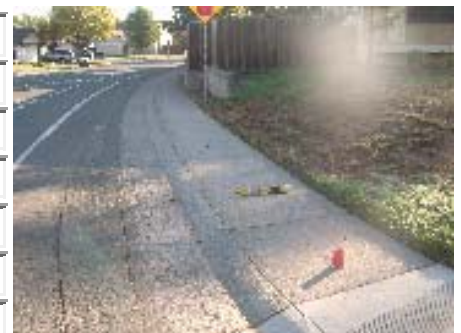
Field Date:	#####	Report Date:	10/19/2010	Barrier #:	962
Location:	Tupelo Dr - South				
X Coordinate:	-121.32516				
Y Coordinate:	38.69867				
Barrier Area:	Sidewalks				
Barrier Type:	Cross Slope - Existing (4.1% to 4.9%)				
Code Ref:	CBC 1133B.7.1.3 and ADA/ABA 403.3

As Built Meas:	217	Quantity:	LF
Description:	Cross slope exceeds 2.0% (4.1% to 4.9%)		
As Built Desc:	4.4% cross slope		
Solution:	Demolish existing and construct new route		
Bar. Severity:	2 Recommended	Cost Estimate:	\$27,125.00
Implementation Priority:	4	Facility Function:	
Implementation Phase:		Implementation Date:	
Official Responsible:			
Notes:

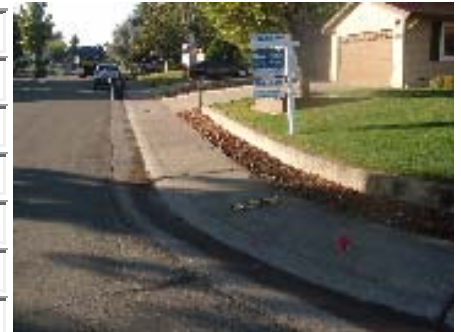
Field Date:	#####	Report Date:	10/19/2010	Barrier #:	963
Location:	Windjammer Wy - West				
X Coordinate:	-121.3244				
Y Coordinate:	38.69879				
Barrier Area:	Sidewalks				
Barrier Type:	Cross Slope - Existing (4.1% to 4.9%)				
Code Ref:	CBC 1133B.7.1.3 and ADA/ABA 403.3

As Built Meas:	560	Quantity:	LF
Description:	Cross slope exceeds 2.0% (4.1% to 4.9%)		
As Built Desc:	4.5% cross slope		
Solution:	Demolish existing and construct new route		
Bar. Severity:	2 Recommended	Cost Estimate:	\$70,000.00
Implementation Priority:	4	Facility Function:	
Implementation Phase:		Implementation Date:	
Official Responsible:			
Notes:

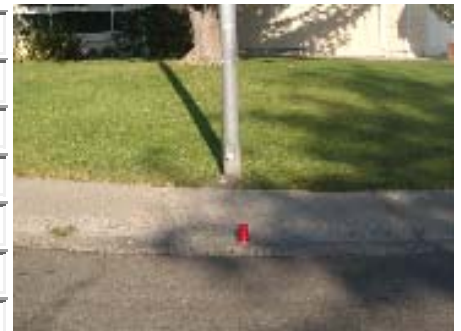
Field Date:	#####	Report Date:	10/19/2010	Barrier #:	964
Location:	Windjammer Wy - West				
X Coordinate:	-121.32459				
Y Coordinate:	38.69712				
Barrier Area:	Sidewalks				
Barrier Type:	Elbow in Sidewalk - Cross Slope (5.0% or more)				
Code Ref:	CBC 1133B.7.1.3 and ADA/ABA 403.3

As Built Meas:	8	Quantity:	LF
Description:	Cross slope at elbow exceeds 2.0% (5.0% or more)		
As Built Desc:	10.5% cross slope		
Solution:	Demolish existing and construct new sidewalk without curb ramp		
Bar. Severity:	1 Necessary	Cost Estimate:	\$1,000.00
Implementation Priority:	4	Facility Function:	
Implementation Phase:		Implementation Date:	
Official Responsible:			
Notes:

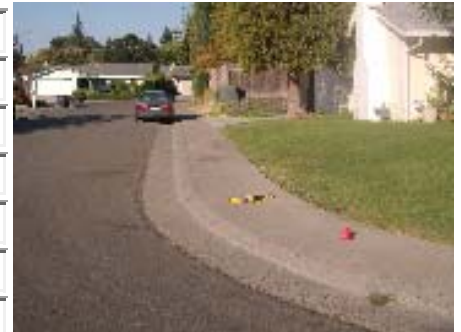
Field Date:	#####	Report Date:	10/19/2010	Barrier #:	965
Location:	Windjammer Wy - North				
X Coordinate:	-121.32453				
Y Coordinate:	38.69713				
Barrier Area:	Sidewalks				
Barrier Type:	Cross Slope - Existing (4.1% to 4.9%)				
Code Ref:	CBC 1133B.7.1.3 and ADA/ABA 403.3

As Built Meas:	174	Quantity:	LF
Description:	Cross slope exceeds 2.0% (4.1% to 4.9%)		
As Built Desc:	4.2% cross slope		
Solution:	Demolish existing and construct new route		
Bar. Severity:	2 Recommended	Cost Estimate:	\$21,750.00
Implementation Priority:	4	Facility Function:	
Implementation Phase:		Implementation Date:	
Official Responsible:			
Notes:

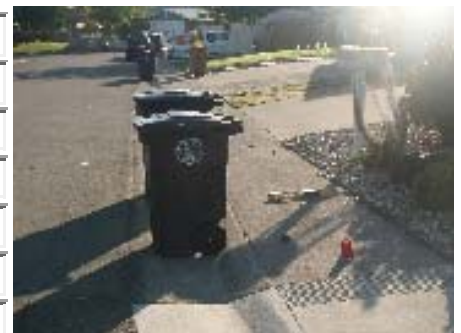
Field Date:	#####	Report Date:	10/19/2010	Barrier #:	966
Location:	Windjammer Wy - South				
X Coordinate:	-121.32509				
Y Coordinate:	38.69712				
Barrier Area:	Sidewalks				
Barrier Type:	Cross Slope - Existing (3.1% to 4.0%)				
Code Ref:	CBC 1133B.7.1.3 and ADA/ABA 403.3

As Built Meas:	214	Quantity:	LF
Description:	Cross slope exceeds 2.0% (3.1% to 4.0%)		
As Built Desc:	3.5% cross slope		
Solution:	Demolish existing and construct new route		
Bar. Severity:	3 Hindrance	Cost Estimate:	\$26,750.00
Implementation Priority:	4	Facility Function:	
Implementation Phase:		Implementation Date:	
Official Responsible:			
Notes:

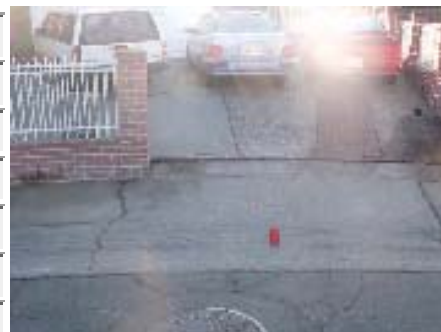
Barrier Type: Elbow in Sidewalk - Cross Slope (5.0% or more)

As Built Meas: 10 Quantity: LF

Description: Cross slope at elbow exceeds 2.0% (5.0% or more)

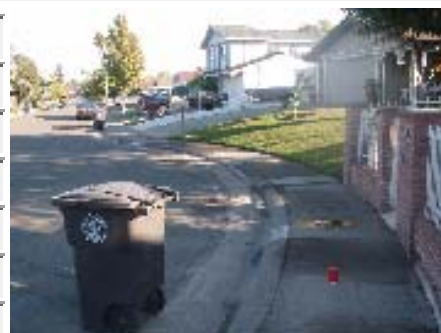
Barrier Type: Cross Slope - Existing (5.0% or more)

As Built Meas: 607 Quantity: LF

Description: Cross slope exceeds 2.0% (5.0% or more)

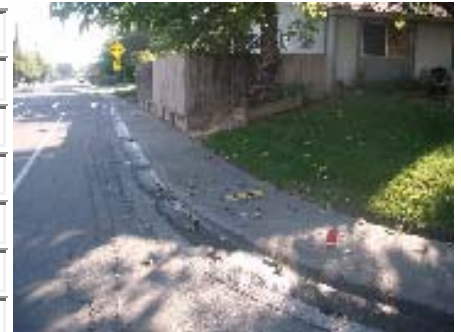
Field Date:	#####	Report Date:	10/19/2010	Barrier #:	969
Location:	Tupelo Dr - South				
X Coordinate:	-121.32421				
Y Coordinate:	38.69887				
Barrier Area:	Sidewalks				
Barrier Type:	Cross Slope - Existing (5.0% or more)				
Code Ref:	CBC 1133B.7.1.3 and ADA/ABA 403.3

As Built Meas:	188	Quantity:	LF
Description:	Cross slope exceeds 2.0% (5.0% or more)		
As Built Desc:	5.2% cross slope		
Solution:	Demolish existing and construct new route		
Bar. Severity:	1 Necessary	Cost Estimate:	\$23,500.00
Implementation Priority:	4	Facility Function:	
Implementation Phase:		Implementation Date:	
Official Responsible:			
Notes:

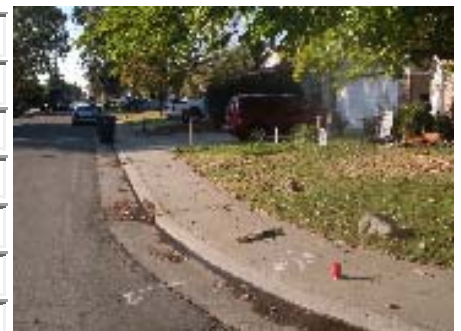
Field Date:	#####	Report Date:	10/19/2010	Barrier #:	970A
Location:	Parkvale Wy - West				
X Coordinate:	-121.32352				
Y Coordinate:	38.69882				
Barrier Area:	Sidewalks				
Barrier Type:	Cross Slope - Existing (5.0% or more)				
Code Ref:	CBC 1133B.7.1.3 and ADA/ABA 403.3

As Built Meas:	1136	Quantity:	LF
Description:	Cross slope exceeds 2.0% (5.0% or more)		
As Built Desc:	5.5% cross slope		
Solution:	Demolish existing and construct new route		
Bar. Severity:	1 Necessary	Cost Estimate:	\$142,000.00
Implementation Priority:	4	Facility Function:	
Implementation Phase:		Implementation Date:	
Official Responsible:			
Notes:

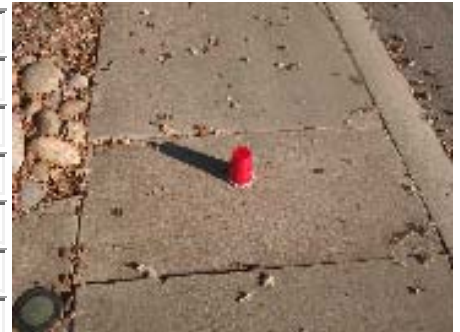
Field Date:	#####	Report Date:	10/19/2010	Barrier #:	970B
Location:	Parkvale Wy - West				
X Coordinate:	-121.32358				
Y Coordinate:	38.69782				
Barrier Area:	Sidewalks				
Barrier Type:	Abrupt Change in Level - Tree Heaves				
Code Ref:	CBC 1133B.7.1 and ADA/ABA 303.3

As Built Meas:	4	Quantity:	LF		
Description:	Change in level greater than 1/2"				
As Built Desc:	1/2" lip due to tree heaves				
Solution:	Grind or repair sidewalk to remove trip hazard				
Bar. Severity:	1 Necessary	Cost Estimate:	\$1,000.00	Status:	
Implementation Priority:	4	Facility Function:			
Implementation Phase:		Implementation Date:			
Official Responsible:					
Notes:

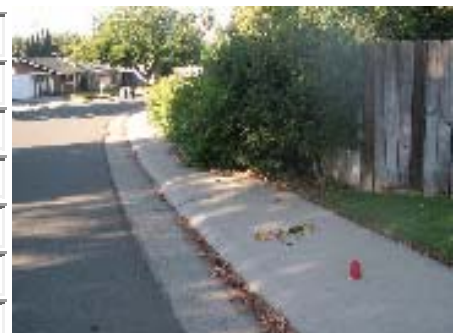
Field Date:	#####	Report Date:	10/19/2010	Barrier #:	971A
Location:	Parkvale Wy - North				
X Coordinate:	-121.32377				
Y Coordinate:	38.69571				
Barrier Area:	Sidewalks				
Barrier Type:	Cross Slope - Existing (4.1% to 4.9%)				
Code Ref:	CBC 1133B.7.1.3 and ADA/ABA 403.3

As Built Meas:	176	Quantity:	LF		
Description:	Cross slope exceeds 2.0% (4.1% to 4.9%)				
As Built Desc:	4.6% cross slope				
Solution:	Demolish existing and construct new route				
Bar. Severity:	2 Recommended	Cost Estimate:	\$22,000.00	Status:	
Implementation Priority:	4	Facility Function:			
Implementation Phase:		Implementation Date:			
Official Responsible:					
Notes:

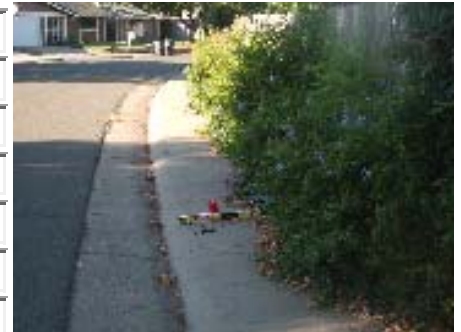
Field Date: ##### Report Date: 10/19/2010 Barrier #: 971B

Barrier Type: Clear Width - Existing ($\leq 31"$ or less)

Code Ref: CBC 1133B.7.1

As Built Meas: 1 Quantity: LF

Description: Pedestrian route is not min. 48" wide ($\leq 31"$ or less)

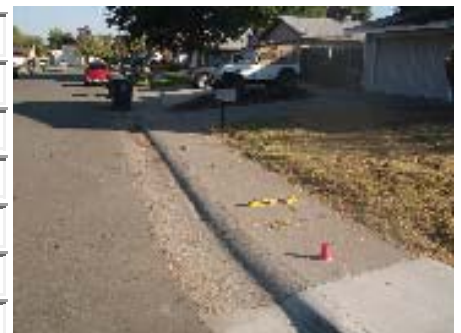
Barrier Type: Cross Slope - Existing (4.1% to 4.9%)

Code Ref: CBC 1133B.7.1.3 and ADA/ABA 403.3

As Built Meas: 303 Quantity: LF

Description: Cross slope exceeds 2.0% (4.1% to 4.9%)

Bar. Severity: 2 Recommended Cost Estimate: \$37,875.00 Status:

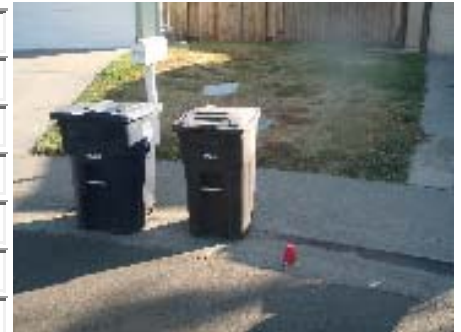
Field Date:	#####	Report Date:	10/19/2010	Barrier #:	973
Location:	Schooner Wy - East				
X Coordinate:	-121.32433				
Y Coordinate:	38.6964				
Barrier Area:	Sidewalks				
Barrier Type:	Elbow in Sidewalk - Cross Slope (5.0% or more)				
Code Ref:	CBC 1133B.7.1.3 and ADA/ABA 403.3

As Built Meas:	10	Quantity:	LF
Description:	Cross slope at elbow exceeds 2.0% (5.0% or more)		
As Built Desc:	11.3% cross slope		
Solution:	Demolish existing and construct new sidewalk without curb ramp		
Bar. Severity:	1 Necessary	Cost Estimate:	\$1,250.00
Implementation Priority:	4	Facility Function:	
Implementation Phase:		Implementation Date:	
Official Responsible:			
Notes:

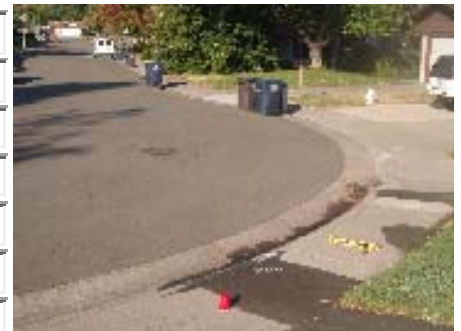
Field Date:	#####	Report Date:	10/19/2010	Barrier #:	974A
Location:	Schooner Wy - North				
X Coordinate:	-121.32427				
Y Coordinate:	38.69651				
Barrier Area:	Sidewalks				
Barrier Type:	Cross Slope - Existing (4.1% to 4.9%)				
Code Ref:	CBC 1133B.7.1.3 and ADA/ABA 403.3

As Built Meas:	257	Quantity:	LF
Description:	Cross slope exceeds 2.0% (4.1% to 4.9%)		
As Built Desc:	4.6% cross slope		
Solution:	Demolish existing and construct new route		
Bar. Severity:	2 Recommended	Cost Estimate:	\$32,125.00
Implementation Priority:	4	Facility Function:	
Implementation Phase:		Implementation Date:	
Official Responsible:			
Notes:

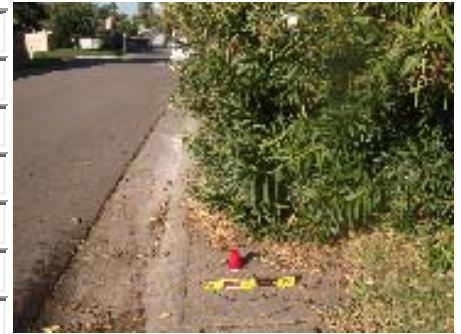
Field Date: ##### Report Date: 10/19/2010 Barrier #: 974B

Barrier Type: Clear Width - Existing ($\leq 31"$ or less)

Code Ref: CBC 1133B.7.1

As Built Meas: 1 Quantity: LF

Description: Pedestrian route is not min. 48" wide ($\leq 31"$ or less)

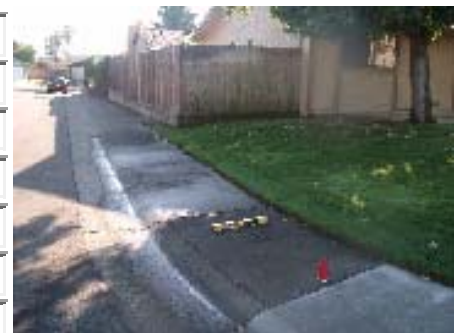
Barrier Type: Cross Slope - Existing (4.1% to 4.9%)

Code Ref: CBC 1133B.7.1.3 and ADA/ABA 403.3

As Built Meas: 186 Quantity: LF

Description: Cross slope exceeds 2.0% (4.1% to 4.9%)

Bar. Severity: 2 Recommended Cost Estimate: \$23,250.00 Status:

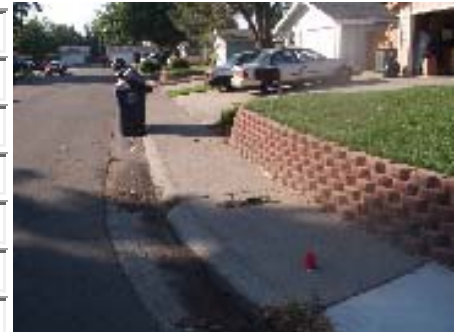
Field Date:	#####	Report Date:	10/19/2010	Barrier #:	976
Location:	Schooner Wy - West				
X Coordinate:	-121.3244				
Y Coordinate:	38.69639				
Barrier Area:	Sidewalks				
Barrier Type:	Cross Slope - Existing (4.1% to 4.9%)				
Code Ref:	CBC 1133B.7.1.3 and ADA/ABA 403.3

As Built Meas:	286	Quantity:	LF
Description:	Cross slope exceeds 2.0% (4.1% to 4.9%)		
As Built Desc:	4.4% cross slope		
Solution:	Demolish existing and construct new route		
Bar. Severity:	2 Recommended	Cost Estimate:	\$35,750.00
Implementation Priority:	4	Facility Function:	
Implementation Phase:		Implementation Date:	
Official Responsible:			
Notes:

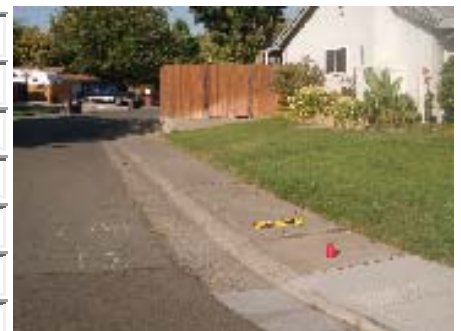
Field Date:	#####	Report Date:	10/19/2010	Barrier #:	977
Location:	Parkvale Wy - North				
X Coordinate:	-121.32453				
Y Coordinate:	38.69562				
Barrier Area:	Sidewalks				
Barrier Type:	Cross Slope - Existing (4.1% to 4.9%)				
Code Ref:	CBC 1133B.7.1.3 and ADA/ABA 403.3

As Built Meas:	228	Quantity:	LF
Description:	Cross slope exceeds 2.0% (4.1% to 4.9%)		
As Built Desc:	4.6% cross slope		
Solution:	Demolish existing and construct new route		
Bar. Severity:	2 Recommended	Cost Estimate:	\$28,500.00
Implementation Priority:	4	Facility Function:	
Implementation Phase:		Implementation Date:	
Official Responsible:			
Notes:

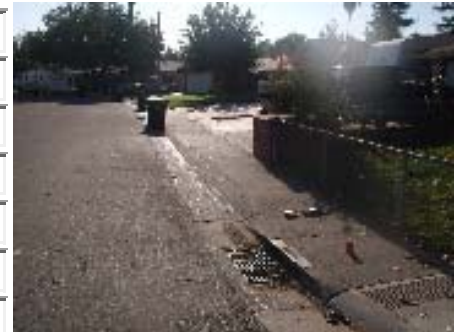
Field Date:	#####	Report Date:	10/19/2010	Barrier #:	978
Location:	Parkvale Wy - South				
X Coordinate:	-121.32528				
Y Coordinate:	38.69568				
Barrier Area:	Sidewalks				
Barrier Type:	Cross Slope - Existing (4.1% to 4.9%)				
Code Ref:	CBC 1133B.7.1.3 and ADA/ABA 403.3

As Built Meas:	430	Quantity:	LF
Description:	Cross slope exceeds 2.0% (4.1% to 4.9%)		
As Built Desc:	4.6% cross slope		
Solution:	Demolish existing and construct new route		
Bar. Severity:	2 Recommended	Cost Estimate:	\$53,750.00
Implementation Priority:	4	Facility Function:	
Implementation Phase:		Implementation Date:	
Official Responsible:			
Notes:

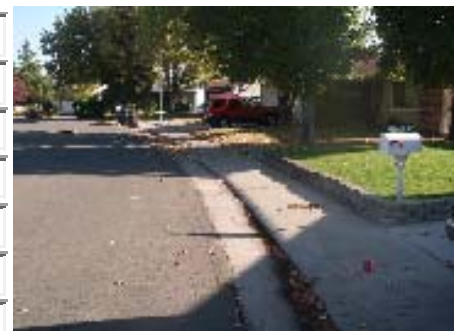
Field Date:	#####	Report Date:	10/19/2010	Barrier #:	979A
Location:	Parkvale Wy - East				
X Coordinate:	-121.32378				
Y Coordinate:	38.69559				
Barrier Area:	Sidewalks				
Barrier Type:	Cross Slope - Existing (4.1% to 4.9%)				
Code Ref:	CBC 1133B.7.1.3 and ADA/ABA 403.3

As Built Meas:	467	Quantity:	LF
Description:	Cross slope exceeds 2.0% (4.1% to 4.9%)		
As Built Desc:	4.2% cross slope		
Solution:	Demolish existing and construct new route		
Bar. Severity:	2 Recommended	Cost Estimate:	\$58,375.00
Implementation Priority:	4	Facility Function:	
Implementation Phase:		Implementation Date:	
Official Responsible:			
Notes:

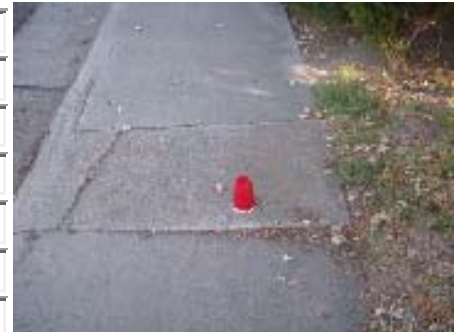
Field Date:	#####	Report Date:	10/19/2010	Barrier #:	979B
Location:	Parkvale Wy - East				
X Coordinate:	-121.32351				
Y Coordinate:	38.69593				
Barrier Area:	Sidewalks				
Barrier Type:	Abrupt Change in Level - Tree Heaves				
Code Ref:	CBC 1133B.7.1 and ADA/ABA 303.3

As Built Meas:	4	Quantity:	LF
Description:	Change in level greater than 1/2"		
As Built Desc:	1/2" lip due to tree heaves		
Solution:	Grind or repair sidewalk to remove trip hazard		
Bar. Severity:	1 Necessary	Cost Estimate:	\$1,000.00
Implementation Priority:	4	Facility Function:	
Implementation Phase:		Implementation Date:	
Official Responsible:			
Notes:

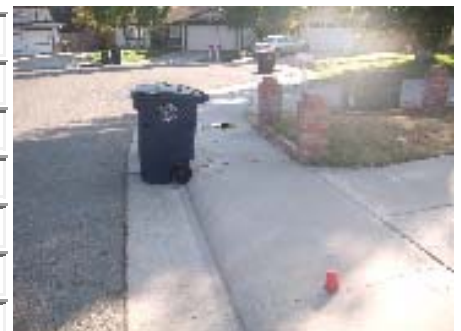
Field Date:	#####	Report Date:	10/19/2010	Barrier #:	988
Location:	Shawnda Ct - South				
X Coordinate:	-121.32279				
Y Coordinate:	38.69699				
Barrier Area:	Sidewalks				
Barrier Type:	Cross Slope - New Construction				
Code Ref:	CBC 1133B.7.1.3 and ADA/ABA 403.3

As Built Meas:	114	Quantity:	LF
Description:	Cross slope exceeds 2.0% in new construction		
As Built Desc:	4.1% cross slope		
Solution:	Demolish existing and construct new route		
Bar. Severity:	1 Necessary	Cost Estimate:	\$14,250.00
Implementation Priority:	4	Facility Function:	
Implementation Phase:		Implementation Date:	
Official Responsible:			
Notes:

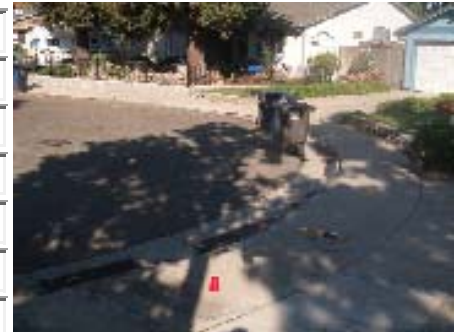
Field Date:	#####	Report Date:	10/19/2010	Barrier #:	989
Location:	Shawnda Ct - North				
X Coordinate:	-121.32233				
Y Coordinate:	38.69696				
Barrier Area:	Sidewalks				
Barrier Type:	Cross Slope - Existing (5.0% or more)				
Code Ref:	CBC 1133B.7.1.3 and ADA/ABA 403.3

As Built Meas:	330	Quantity:	LF
Description:	Cross slope exceeds 2.0% (5.0% or more)		
As Built Desc:	5.2% cross slope		
Solution:	Demolish existing and construct new route		
Bar. Severity:	1 Necessary	Cost Estimate:	\$41,250.00
Implementation Priority:	4	Facility Function:	
Implementation Phase:		Implementation Date:	
Official Responsible:			
Notes:

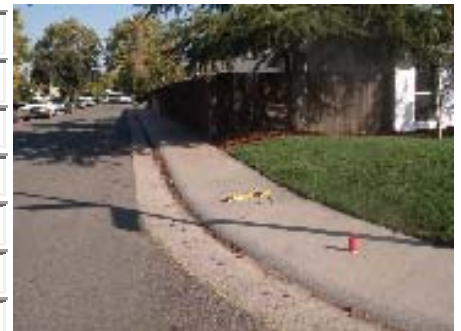
Field Date:	#####	Report Date:	10/19/2010	Barrier #:	990
Location:	Parkvale Wy - East				
X Coordinate:	-121.32346				
Y Coordinate:	38.69711				
Barrier Area:	Sidewalks				
Barrier Type:	Cross Slope - Existing (5.0% or more)				
Code Ref:	CBC 1133B.7.1.3 and ADA/ABA 403.3

As Built Meas:	179	Quantity:	LF
Description:	Cross slope exceeds 2.0% (5.0% or more)		
As Built Desc:	5.0% cross slope		
Solution:	Demolish existing and construct new route		
Bar. Severity:	1 Necessary	Cost Estimate:	\$22,375.00
Implementation Priority:	4	Facility Function:	
Implementation Phase:		Implementation Date:	
Official Responsible:			
Notes:

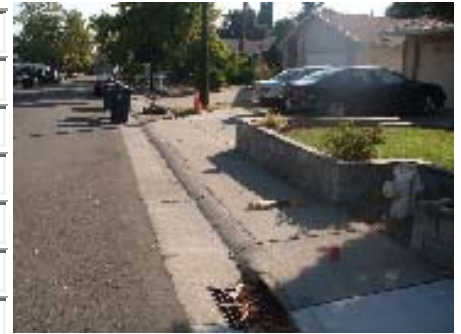
Field Date:	#####	Report Date:	10/19/2010	Barrier #:	991
Location:	Sierravale Wy - South				
X Coordinate:	-121.32333				
Y Coordinate:	38.69765				
Barrier Area:	Sidewalks				
Barrier Type:	Cross Slope - Existing (5.0% or more)				
Code Ref:	CBC 1133B.7.1.3 and ADA/ABA 403.3

As Built Meas:	426	Quantity:	LF
Description:	Cross slope exceeds 2.0% (5.0% or more)		
As Built Desc:	6.2% cross slope		
Solution:	Demolish existing and construct new route		
Bar. Severity:	1 Necessary	Cost Estimate:	\$53,250.00
Implementation Priority:	4	Facility Function:	
Implementation Phase:		Implementation Date:	
Official Responsible:			
Notes:

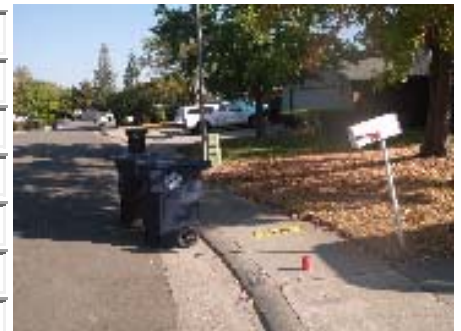
Field Date:	#####	Report Date:	10/19/2010	Barrier #:	992A
Location:	Sierravale Wy - East				
X Coordinate:	-121.32181				
Y Coordinate:	38.69768				
Barrier Area:	Sidewalks				
Barrier Type:	Cross Slope - Existing (5.0% or more)				
Code Ref:	CBC 1133B.7.1.3 and ADA/ABA 403.3

As Built Meas:	423	Quantity:	LF
Description:	Cross slope exceeds 2.0% (5.0% or more)		
As Built Desc:	5.0% cross slope		
Solution:	Demolish existing and construct new route		
Bar. Severity:	1 Necessary	Cost Estimate:	\$52,875.00
Implementation Priority:	4	Facility Function:	
Implementation Phase:		Implementation Date:	
Official Responsible:			
Notes:

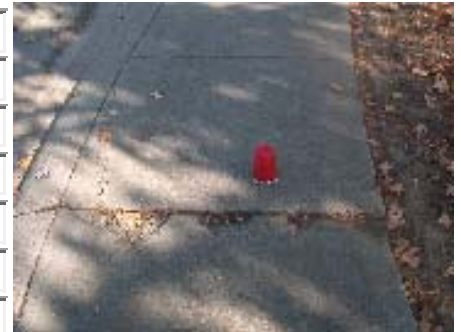
Field Date: ##### Report Date: 10/19/2010 Barrier #: 992B

Barrier Type: Abrupt Change in Level - > 1/2"

Code Ref: CBC 1133B.7.1 and ADA/ABA 303.3

As Built Meas: 4 Quantity: LF

Description: Change in level greater than 1/2"

Solution: Grind or repair sidewalk to remove trip hazard

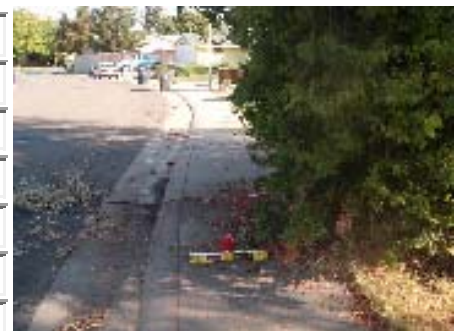
Barrier Type: Clear Width - Existing ($\leq 31"$ or less)

Code Ref: CBC 1133B.7.1

As Built Meas: 1 Quantity: LF

Description: Pedestrian route is not min. 48" wide ($\leq 31"$ or less)

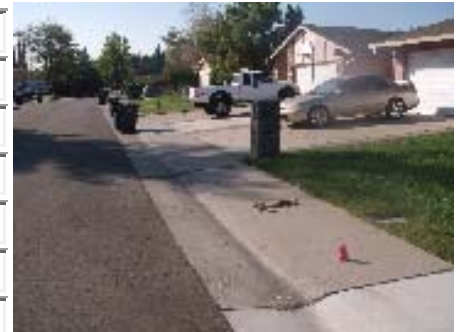
Field Date:	#####	Report Date:	10/19/2010	Barrier #:	993
Location:	Sierravale Wy - West				
X Coordinate:	-121.32168				
Y Coordinate:	38.69884				
Barrier Area:	Sidewalks				
Barrier Type:	Cross Slope - Existing (5.0% or more)				
Code Ref:	CBC 1133B.7.1.3 and ADA/ABA 403.3

As Built Meas:	411	Quantity:	LF
Description:	Cross slope exceeds 2.0% (5.0% or more)		
As Built Desc:	6.0% cross slope		
Solution:	Demolish existing and construct new route		
Bar. Severity:	1 Necessary	Cost Estimate:	\$51,375.00
Implementation Priority:	4	Facility Function:	
Implementation Phase:		Implementation Date:	
Official Responsible:			
Notes:

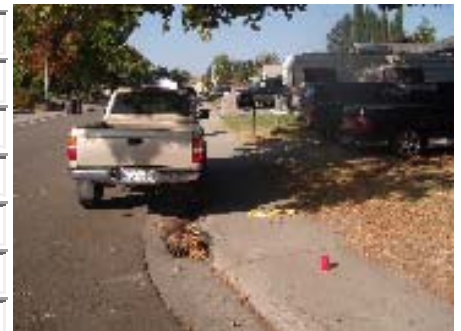
Field Date:	#####	Report Date:	10/19/2010	Barrier #:	994
Location:	Sierravale Wy - North				
X Coordinate:	-121.32194				
Y Coordinate:	38.69773				
Barrier Area:	Sidewalks				
Barrier Type:	Cross Slope - Existing (5.0% or more)				
Code Ref:	CBC 1133B.7.1.3 and ADA/ABA 403.3

As Built Meas:	394	Quantity:	LF
Description:	Cross slope exceeds 2.0% (5.0% or more)		
As Built Desc:	5.5% cross slope		
Solution:	Demolish existing and construct new route		
Bar. Severity:	1 Necessary	Cost Estimate:	\$49,250.00
Implementation Priority:	4	Facility Function:	
Implementation Phase:		Implementation Date:	
Official Responsible:			
Notes:

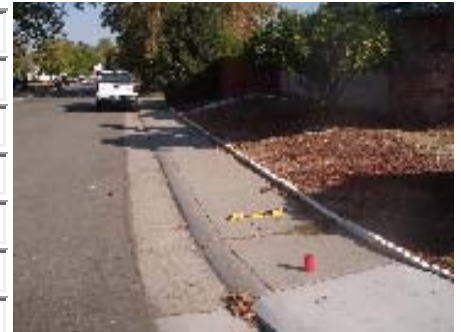
Field Date:	#####	Report Date:	10/19/2010	Barrier #:	995
Location:	Parkvale Wy - East				
X Coordinate:	-121.32343				
Y Coordinate:	38.69778				
Barrier Area:	Sidewalks				
Barrier Type:	Cross Slope - Existing (5.0% or more)				
Code Ref:	CBC 1133B.7.1.3 and ADA/ABA 403.3

As Built Meas:	390	Quantity:	LF
Description:	Cross slope exceeds 2.0% (5.0% or more)		
As Built Desc:	5.6% cross slope		
Solution:	Demolish existing and construct new route		
Bar. Severity:	1 Necessary	Cost Estimate:	\$48,750.00
Implementation Priority:	4	Facility Function:	
Implementation Phase:		Implementation Date:	
Official Responsible:			
Notes:

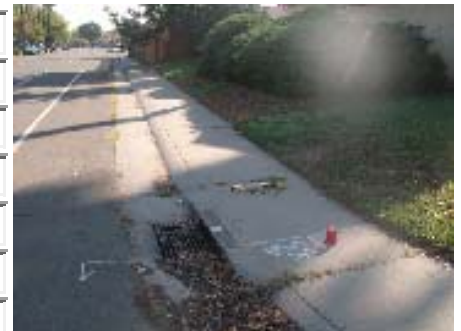
Field Date:	#####	Report Date:	10/19/2010	Barrier #:	996A
Location:	Tupelo Dr - South				
X Coordinate:	-121.32328				
Y Coordinate:	38.69886				
Barrier Area:	Sidewalks				
Barrier Type:	Cross Slope - Existing (5.0% or more)				
Code Ref:	CBC 1133B.7.1.3 and ADA/ABA 403.3

As Built Meas:	192	Quantity:	LF
Description:	Cross slope exceeds 2.0% (5.0% or more)		
As Built Desc:	5.2% cross slope		
Solution:	Demolish existing and construct new route		
Bar. Severity:	1 Necessary	Cost Estimate:	\$24,000.00
Implementation Priority:	4	Facility Function:	
Implementation Phase:		Implementation Date:	
Official Responsible:			
Notes:

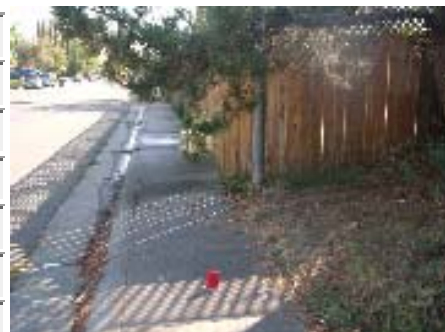
Barrier Type: Protruding Hazard

Description: Protruding object in route of travel between 27" and 80" high

As Built Desc: 40" protruding hazard at tree branches

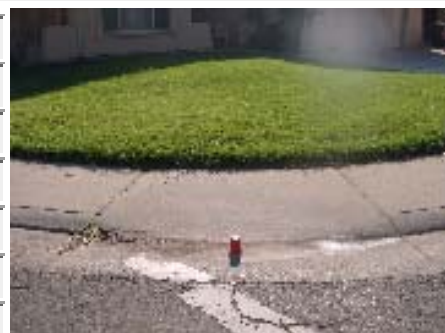
Barrier Type: No Curb Ramp - Depressed Exsiting Curb

Description: No compliant curb cut at corner (intersection)

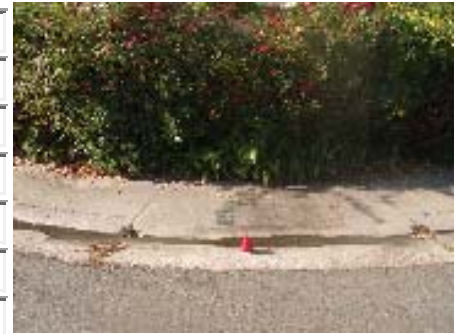
Barrier Type: No Curb Ramp - Depressed Exsiting Curb

Description: No compliant curb cut at corner (intersection)

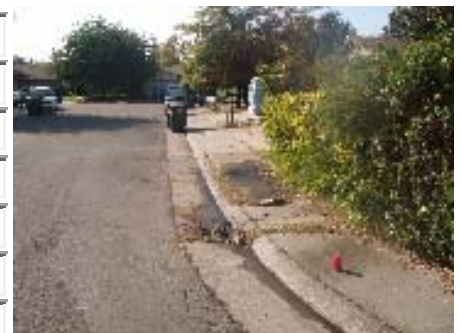
Barrier Type: Cross Slope - Existing (5.0% or more)

Description: Cross slope exceeds 2.0% (5.0% or more)

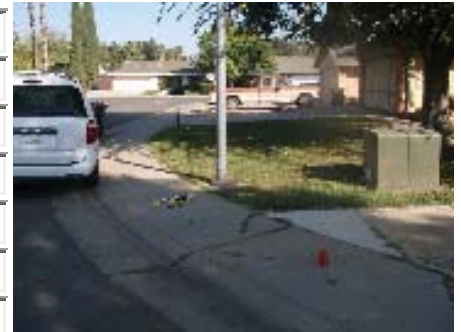
Field Date:	#####	Report Date:	10/19/2010	Barrier #:	1000
Location:	Lillivale Ct - East				
X Coordinate:	-121.32245				
Y Coordinate:	38.69852				
Barrier Area:	Sidewalks				
Barrier Type:	Cross Slope - Existing (4.1% to 4.9%)				
Code Ref:	CBC 1133B.7.1.3 and ADA/ABA 403.3

As Built Meas:	120	Quantity:	LF
Description:	Cross slope exceeds 2.0% (4.1% to 4.9%)		
As Built Desc:	4.5% cross slope		
Solution:	Demolish existing and construct new route		
Bar. Severity:	2 Recommended	Cost Estimate:	\$15,000.00
Implementation Priority:	4	Facility Function:	
Implementation Phase:		Implementation Date:	
Official Responsible:			
Notes:

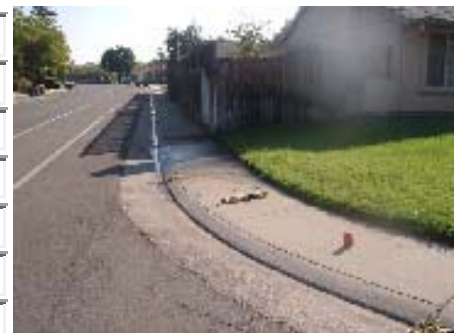
Field Date:	#####	Report Date:	10/19/2010	Barrier #:	1001
Location:	Tupelo Dr - South				
X Coordinate:	-121.32241				
Y Coordinate:	38.6989				
Barrier Area:	Sidewalks				
Barrier Type:	Cross Slope - Existing (5.0% or more)				
Code Ref:	CBC 1133B.7.1.3 and ADA/ABA 403.3

As Built Meas:	195	Quantity:	LF
Description:	Cross slope exceeds 2.0% (5.0% or more)		
As Built Desc:	6.2% cross slope		
Solution:	Demolish existing and construct new route		
Bar. Severity:	1 Necessary	Cost Estimate:	\$24,375.00
Implementation Priority:	4	Facility Function:	
Implementation Phase:		Implementation Date:	
Official Responsible:			
Notes:

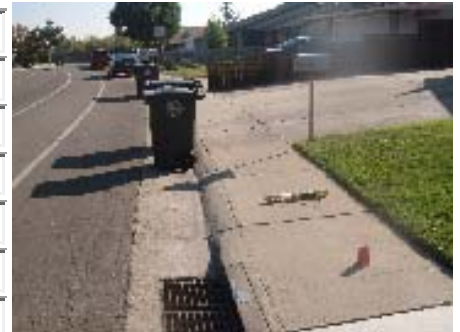
Field Date:	#####	Report Date:	10/19/2010	Barrier #:	1002
Location:	Tupelo Dr - South				
X Coordinate:	-121.32149				
Y Coordinate:	38.6989				
Barrier Area:	Sidewalks				
Barrier Type:	Cross Slope - Existing (5.0% or more)				
Code Ref:	CBC 1133B.7.1.3 and ADA/ABA 403.3

As Built Meas:	727	Quantity:	LF	
Description:	Cross slope exceeds 2.0% (5.0% or more)			
As Built Desc:	6.7% cross slope			
Solution:	Demolish existing and construct new route			
Bar. Severity:	1 Necessary	Cost Estimate:	\$90,875.00	Status:
Implementation Priority:	4	Facility Function:		
Implementation Phase:		Implementation Date:		
Official Responsible:				
Notes:

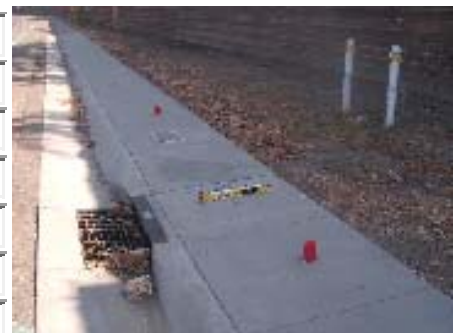
Field Date:	#####	Report Date:	10/19/2010	Barrier #:	1003
Location:	Tupelo Dr - South				
X Coordinate:	-121.31879				
Y Coordinate:	38.6999				
Barrier Area:	Sidewalks				
Barrier Type:	Cross Slope - Existing (4.1% to 4.9%)				
Code Ref:	CBC 1133B.7.1.3 and ADA/ABA 403.3

As Built Meas:	16	Quantity:	LF	
Description:	Cross slope exceeds 2.0% (4.1% to 4.9%)			
As Built Desc:	4.6% cross slope			
Solution:	Demolish existing and construct new route			
Bar. Severity:	2 Recommended	Cost Estimate:	\$2,000.00	Status:
Implementation Priority:	4	Facility Function:		
Implementation Phase:		Implementation Date:		
Official Responsible:				
Notes:

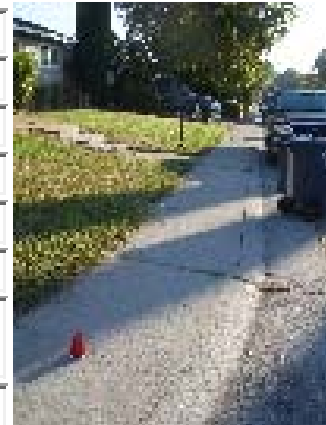
Barrier Type: Cross Slope - Existing (5.0% or more)

Description: Cross slope exceeds 2.0% (5.0% or more)

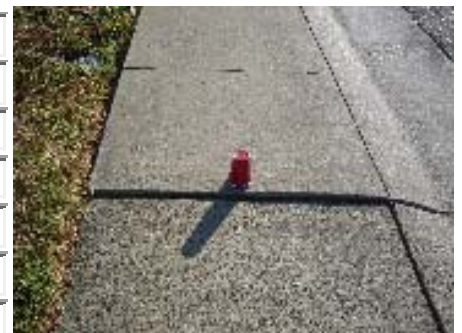
Barrier Type: Abrupt Change in Level - > 1/2"

Description: Change in level greater than 1/2"

Solution: Grind or repair sidewalk to remove trip hazard

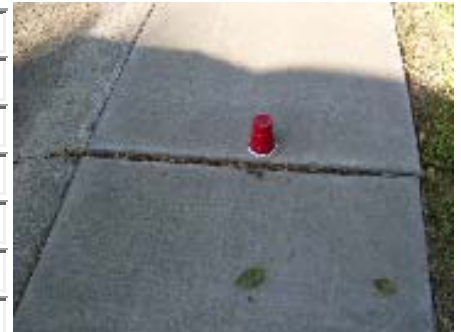
Field Date:	#####	Report Date:	10/19/2010	Barrier #:	1004C
Location:	Woodglade Ave - North				
X Coordinate:	-121.32144				
Y Coordinate:	38.70681				
Barrier Area:	Sidewalks				
Barrier Type:	Abrupt Change in Level - > 1/2"				
Code Ref:	CBC 1133B.7.1 and ADA/ABA 303.3

As Built Meas:	4	Quantity:	LF
Description:	Change in level greater than 1/2"		
As Built Desc:	3/4" lip in sidewalk surface		
Solution:	Grind or repair sidewalk to remove trip hazard		
Bar. Severity:	1 Necessary	Cost Estimate:	\$1,000.00
Implementation Priority:	4	Facility Function:	
Implementation Phase:		Implementation Date:	
Official Responsible:			
Notes:

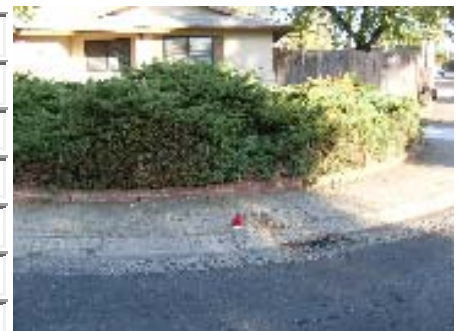
Field Date:	#####	Report Date:	10/19/2010	Barrier #:	1005A
Location:	Woodglade Ave and Saybrook Dr - Corner A				
X Coordinate:	-121.32108				
Y Coordinate:	38.70683				
Barrier Area:	Curb Ramps				
Barrier Type:	No Curb Ramp				
Code Ref:	CBC 1127B.5.1 and ADA/ABA 402.2

As Built Meas:	1	Quantity:	EACH
Description:	No curb cut at corner (intersection)		
As Built Desc:	No curb ramp at corner		
Solution:	Demolish existing and construct curb cut		
Bar. Severity:	1 Necessary	Cost Estimate:	\$2,500.00
Implementation Priority:	4	Facility Function:	
Implementation Phase:		Implementation Date:	
Official Responsible:			
Notes:	Two - way intersection corners A,D

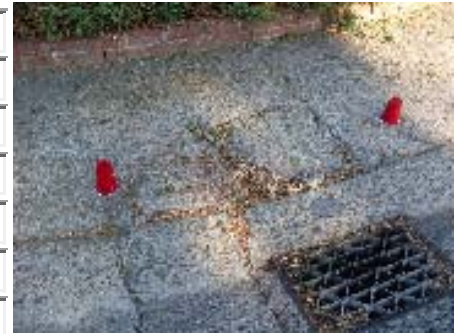
Field Date:	#####	Report Date:	10/19/2010	Barrier #:	1005B
Location:	Woodglade Ave and Saybrook Dr - Corner A				
X Coordinate:	-121.32108				
Y Coordinate:	38.70683				
Barrier Area:	Curb Ramps				
Barrier Type:	Surface Condition				
Code Ref:	CBC 1127B.5 and ADA/ABA 403.2

As Built Meas:	4	Quantity:	SF	
Description:	Surface is not firm and stable (cracked, broken or loose soil, etc.)			
As Built Desc:	Cracked concrete			
Solution:	Repair surface to make firm and stable			
Bar. Severity:	1 Necessary	Cost Estimate:	\$0.00	Status:
Implementation Priority:	4	Facility Function:		
Implementation Phase:		Implementation Date:		
Official Responsible:				
Notes:	Two - way intersection corners A,D

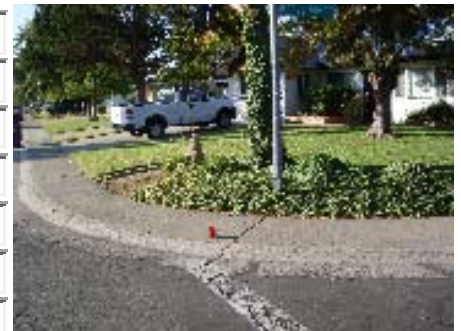
Field Date:	#####	Report Date:	10/19/2010	Barrier #:	1006
Location:	Woodglade Ave and Saybrook Dr - Corner D				
X Coordinate:	-121.3211				
Y Coordinate:	38.70671				
Barrier Area:	Curb Ramps				
Barrier Type:	No Curb Ramp				
Code Ref:	CBC 1127B.5.1 and ADA/ABA 402.2

As Built Meas:	1	Quantity:	EACH	
Description:	No curb cut at corner (intersection)			
As Built Desc:	No curb ramp at corner			
Solution:	Demolish existing and construct curb cut			
Bar. Severity:	1 Necessary	Cost Estimate:	\$2,500.00	Status:
Implementation Priority:	4	Facility Function:		
Implementation Phase:		Implementation Date:		
Official Responsible:				
Notes:	Two - way intersection corners A,D

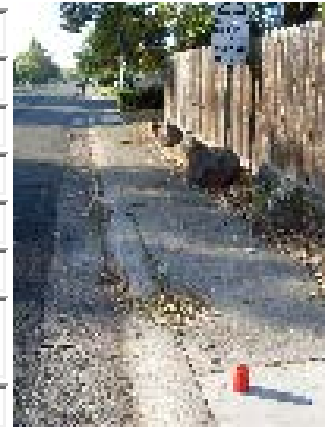
Barrier Type: Cross Slope - Existing (5.0% or more)

Description: Cross slope exceeds 2.0% (5.0% or more)

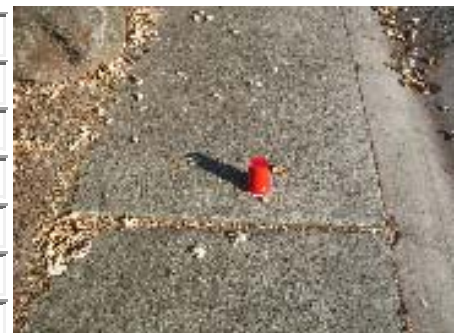
Barrier Type: Abrupt Change in Level - Tree Heaves

Description: Change in level greater than 1/2"

Solution: Grind or repair sidewalk to remove trip hazard

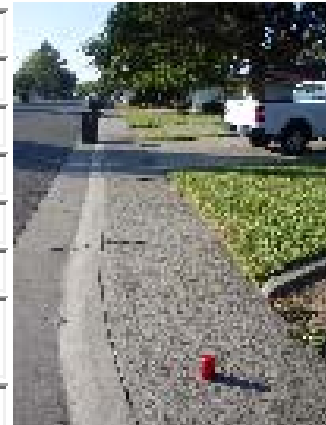
Barrier Type: Cross Slope - Existing (5.0% or more)

Description: Cross slope exceeds 2.0% (5.0% or more)

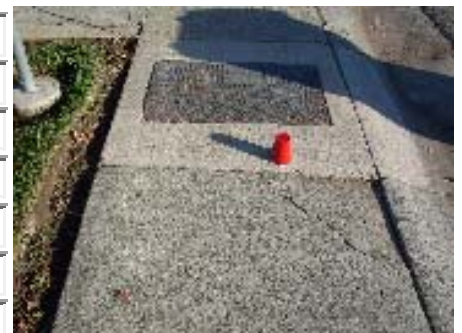
Barrier Type: Surface Condition - Damaged

Description: Surface is not firm and stable (cracked, broken or loose soil, etc.)

As Built Desc: Cracked concrete

Solution: Repair surface to make firm and stable

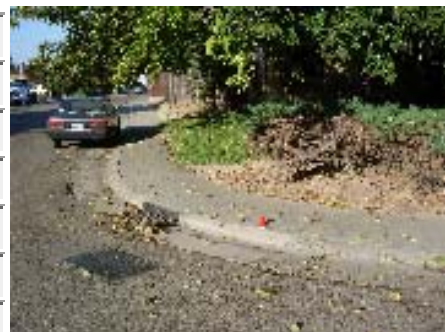
Field Date:	#####	Report Date:	10/19/2010	Barrier #:	1009
Location:	Saybrook Dr and Biglow Dr - Corner A				
X Coordinate:	-121.32105				
Y Coordinate:	38.70443				
Barrier Area:	Curb Ramps				
Barrier Type:	No Curb Ramp				
Code Ref:	CBC 1127B.5.1 and ADA/ABA 402.2

As Built Meas:	1	Quantity:	EACH
Description:	No curb cut at corner (intersection)		
As Built Desc:	No curb ramp at corner		
Solution:	Demolish existing and construct curb cut		
Bar. Severity:	1 Necessary	Cost Estimate:	\$2,500.00
Implementation Priority:	4	Facility Function:	
Implementation Phase:		Implementation Date:	
Official Responsible:			
Notes:	Two - way intersection corners A,D

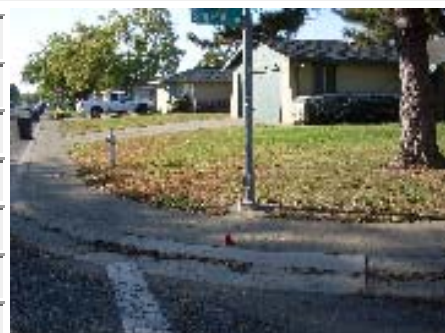
Field Date:	#####	Report Date:	10/19/2010	Barrier #:	1010
Location:	Saybrook Dr and Biglow Dr - Corner D				
X Coordinate:	-121.32105				
Y Coordinate:	38.70426				
Barrier Area:	Curb Ramps				
Barrier Type:	No Curb Ramp				
Code Ref:	CBC 1127B.5.1 and ADA/ABA 402.2

As Built Meas:	1	Quantity:	EACH
Description:	No curb cut at corner (intersection)		
As Built Desc:	No curb ramp at corner		
Solution:	Demolish existing and construct curb cut		
Bar. Severity:	1 Necessary	Cost Estimate:	\$2,500.00
Implementation Priority:	4	Facility Function:	
Implementation Phase:		Implementation Date:	
Official Responsible:			
Notes:	Two - way intersection corners A,D

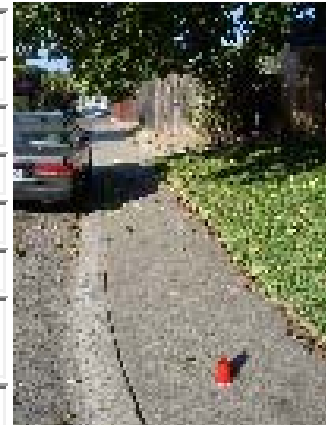
Barrier Type: Cross Slope - Existing (5.0% or more)

Description: Cross slope exceeds 2.0% (5.0% or more)

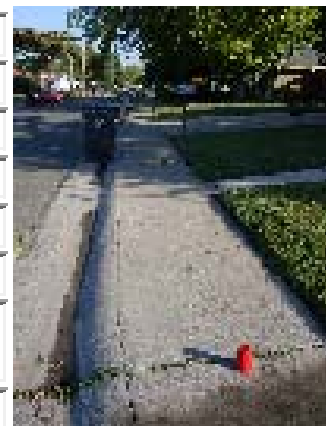
Barrier Type: Cross Slope - Existing (5.0% or more)

Description: Cross slope exceeds 2.0% (5.0% or more)

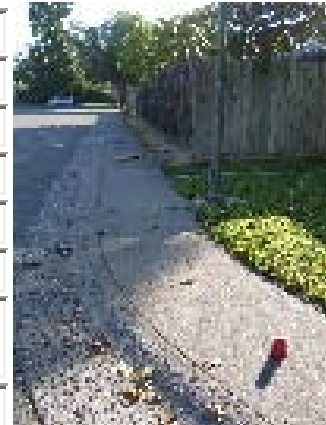
Barrier Type: Cross Slope - Existing (5.0% or more)

Description: Cross slope exceeds 2.0% (5.0% or more)

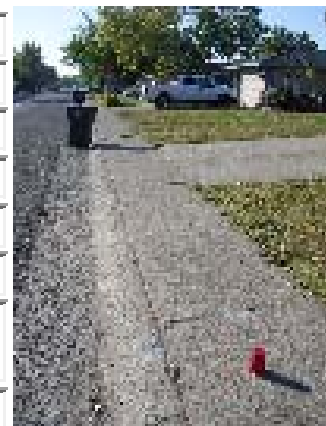
Barrier Type: Cross Slope - Existing (5.0% or more)

Description: Cross slope exceeds 2.0% (5.0% or more)

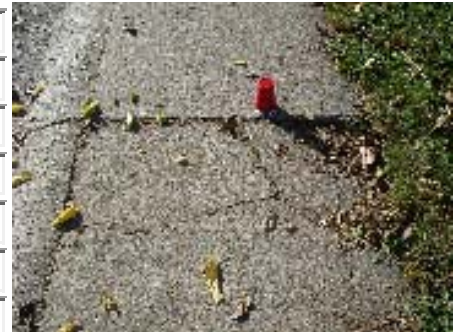
Barrier Type: Surface Condition - Damaged

Description: Surface is not firm and stable (cracked, broken or loose soil, etc.)

As Built Desc: Cracked concrete

Solution: Repair surface to make firm and stable

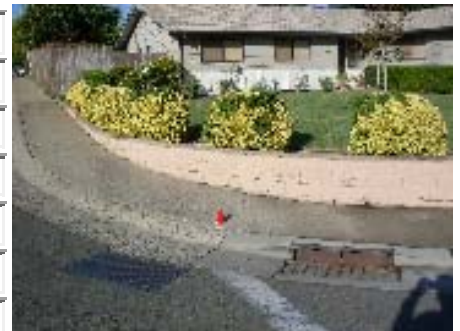
Barrier Type: No Curb Ramp

Description: No curb cut at corner (intersection)

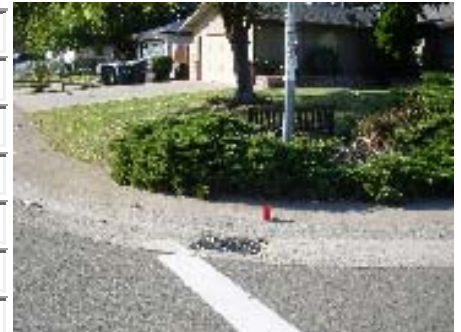
Barrier Type: No Curb Ramp

Description: No curb cut at corner (intersection)

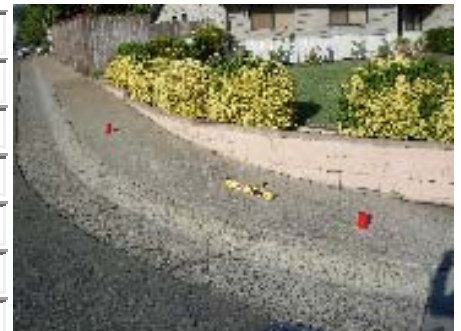
Barrier Type: Running Slope (Existing)

Description: Running slope exceeds 5.0%

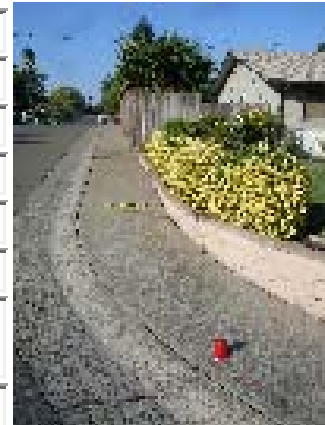
Field Date:	#####	Report Date:	10/19/2010	Barrier #:	1017B
Location:	Birchglade Wy - North				
X Coordinate:	-121.32122				
Y Coordinate:	38.70209				
Barrier Area:	Sidewalks				
Barrier Type:	Cross Slope - Existing (5.0% or more)				
Code Ref:	CBC 1133B.7.1.3 and ADA/ABA 403.3

As Built Meas:	177	Quantity:	LF
Description:	Cross slope exceeds 2.0% (5.0% or more)		
As Built Desc:	6.1% cross slope		
Solution:	Demolish existing and construct new route		
Bar. Severity:	1 Necessary	Cost Estimate:	\$22,125.00
Implementation Priority:	4	Facility Function:	
Implementation Phase:		Implementation Date:	
Official Responsible:			
Notes:

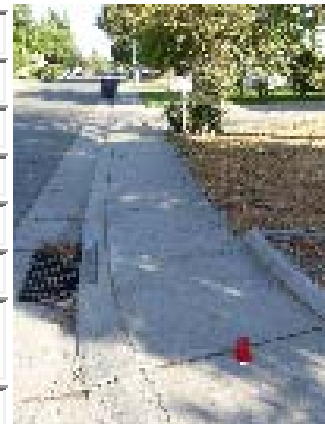
Field Date:	#####	Report Date:	10/19/2010	Barrier #:	1018
Location:	Blackthorne Wy - East				
X Coordinate:	-121.32123				
Y Coordinate:	38.70208				
Barrier Area:	Sidewalks				
Barrier Type:	Cross Slope - Existing (5.0% or more)				
Code Ref:	CBC 1133B.7.1.3 and ADA/ABA 403.3

As Built Meas:	760	Quantity:	LF
Description:	Cross slope exceeds 2.0% (5.0% or more)		
As Built Desc:	6.5% cross slope		
Solution:	Demolish existing and construct new route		
Bar. Severity:	1 Necessary	Cost Estimate:	\$95,000.00
Implementation Priority:	4	Facility Function:	
Implementation Phase:		Implementation Date:	
Official Responsible:			
Notes:

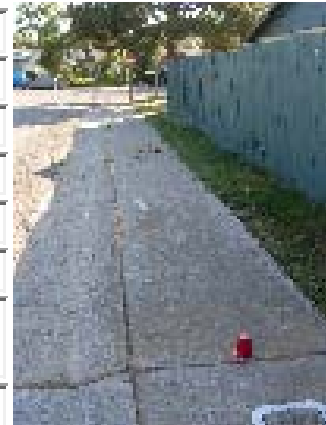
Barrier Type: Cross Slope - Existing (5.0% or more)

Description: Cross slope exceeds 2.0% (5.0% or more)

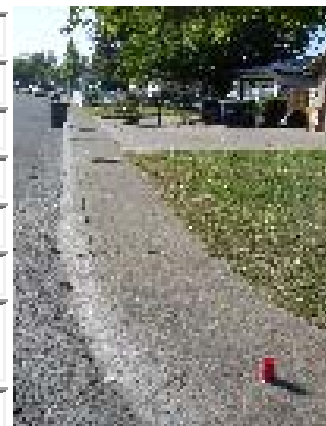
Barrier Type: Cross Slope - Existing (5.0% or more)

Description: Cross slope exceeds 2.0% (5.0% or more)

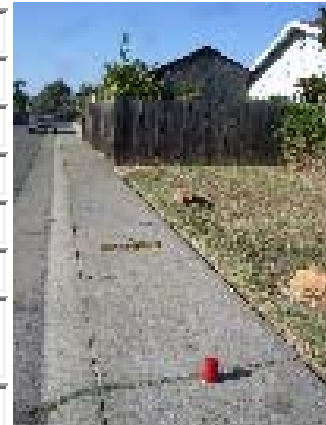
Barrier Type: Cross Slope - Existing (5.0% or more)

Description: Cross slope exceeds 2.0% (5.0% or more)

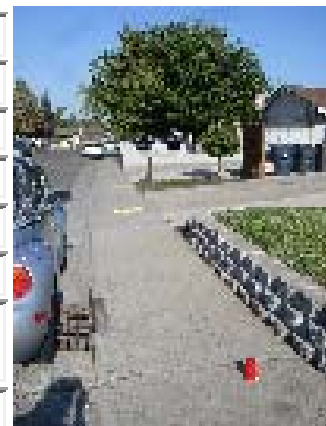
Barrier Type: Cross Slope - Existing (5.0% or more)

Description: Cross slope exceeds 2.0% (5.0% or more)

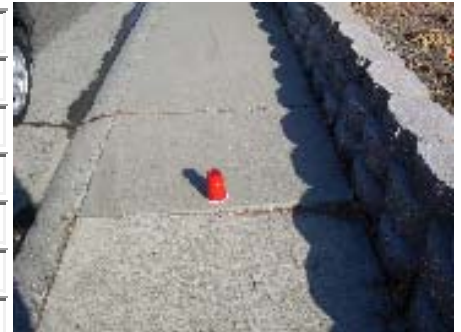
Field Date:	#####	Report Date:	10/19/2010	Barrier #:	1022B
Location:	Blackthorne Wy - North				
X Coordinate:	-121.32094				
Y Coordinate:	38.7012				
Barrier Area:	Sidewalks				
Barrier Type:	Abrupt Change in Level - > 1/2"				
Code Ref:	CBC 1133B.7.1 and ADA/ABA 303.3

As Built Meas:	4	Quantity:	LF		
Description:	Change in level greater than 1/2"				
As Built Desc:	1" lip in sidewalk surface				
Solution:	Grind or repair sidewalk to remove trip hazard				
Bar. Severity:	1 Necessary	Cost Estimate:	\$1,000.00	Status:	
Implementation Priority:	4	Facility Function:			
Implementation Phase:		Implementation Date:			
Official Responsible:					
Notes:

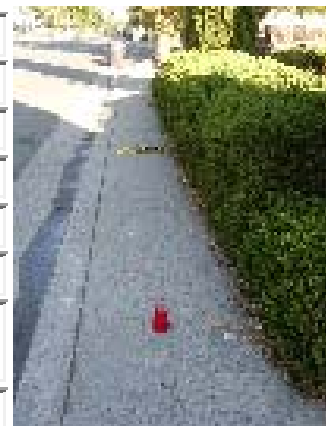
Field Date:	#####	Report Date:	10/19/2010	Barrier #:	1022C
Location:	Blackthorne Wy - North				
X Coordinate:	-121.32114				
Y Coordinate:	38.70166				
Barrier Area:	Sidewalks				
Barrier Type:	Clear Width - Existing ($\leq 31"$ or less)				
Code Ref:	CBC 1133B.7.1

As Built Meas:	1	Quantity:	LF		
Description:	Pedestrian route is not min. 48" wide ($\leq 31"$ or less)				
As Built Desc:	30" clear width due to foliage				
Solution:	Trim foliage to provide min. 48" clear width				
Bar. Severity:	1 Necessary	Cost Estimate:	\$125.00	Status:	
Implementation Priority:	4	Facility Function:			
Implementation Phase:		Implementation Date:			
Official Responsible:					
Notes:

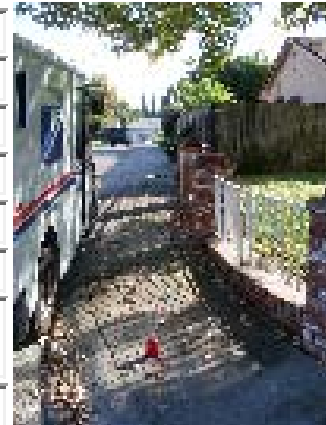
Field Date: ##### Report Date: 10/19/2010 Barrier #: 1023A

Barrier Type: Cross Slope - Existing (5.0% or more)

Description: Cross slope exceeds 2.0% (5.0% or more)

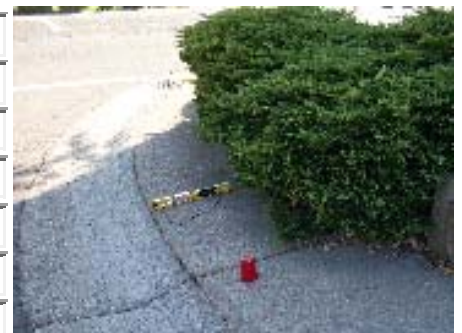
Barrier Type: Clear Width - Existing ($\leq 31"$ or less)

Description: Pedestrian route is not min. 48" wide ($\leq 31"$ or less)

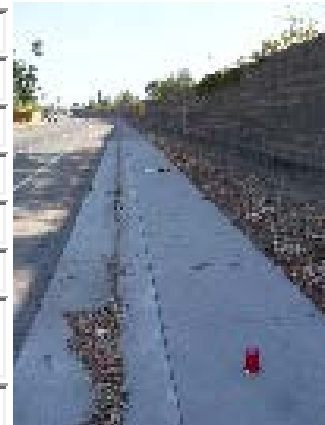
Field Date:	#####	Report Date:	10/19/2010	Barrier #:	1024A
Location:	Tupelo Dr - East				
X Coordinate:	-121.31869				
Y Coordinate:	38.69995				
Barrier Area:	Sidewalks				
Barrier Type:	Cross Slope - New Construction				
Code Ref:	CBC 1133B.7.1.3 and ADA/ABA 403.3

As Built Meas:	1615	Quantity:	LF	
Description:	Cross slope exceeds 2.0% in new construction			
As Built Desc:	5.6% cross slope			
Solution:	Demolish existing and construct new route			
Bar. Severity:	1 Necessary	Cost Estimate:	\$201,875.00	Status:
Implementation Priority:	4	Facility Function:		
Implementation Phase:		Implementation Date:		
Official Responsible:				
Notes:

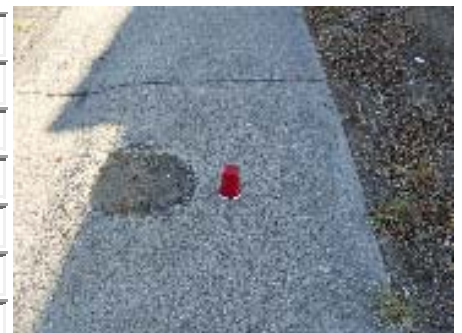
Field Date:	#####	Report Date:	10/19/2010	Barrier #:	1024B
Location:	Tupelo Dr - East				
X Coordinate:	-121.31578				
Y Coordinate:	38.70263				
Barrier Area:	Sidewalks				
Barrier Type:	Surface Condition - Damaged				
Code Ref:	CBC 1133B.7.1 and ADA/ABA 302.1

As Built Meas:	4	Quantity:	LF	
Description:	Surface is not firm and stable (cracked, broken or loose soil, etc.)			
As Built Desc:	Cracked concrete			
Solution:	Repair surface to make firm and stable			
Bar. Severity:	1 Necessary	Cost Estimate:	\$500.00	Status:
Implementation Priority:	4	Facility Function:		
Implementation Phase:		Implementation Date:		
Official Responsible:				
Notes:

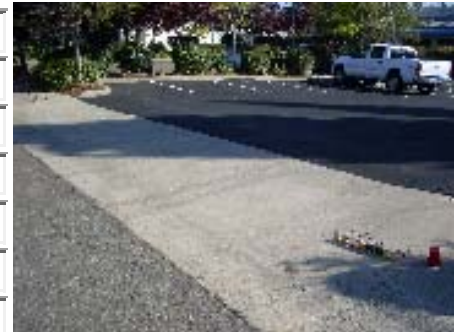
Field Date: ##### Report Date: 10/19/2010 Barrier #: 1025

Barrier Type: Driveway - New Construction

Description: Driveway cross/running slope exceeds 2.0%

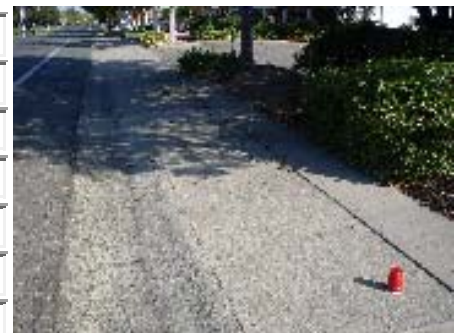
Barrier Type: Cross Slope - Existing (5.0% or more)

Description: Cross slope exceeds 2.0% (5.0% or more)

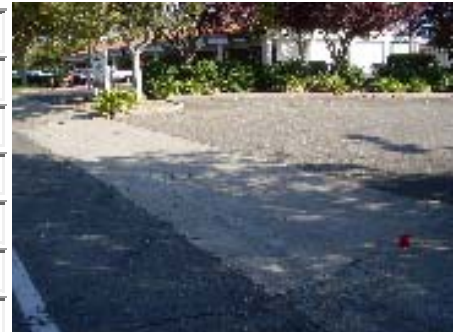
Field Date:	#####	Report Date:	10/19/2010	Barrier #:	1027
Location:	Tupelo Dr - East				
X Coordinate:	-121.31536				
Y Coordinate:	38.7036				
Barrier Area:	Sidewalks				
Barrier Type:	Driveway - New Construction				
Code Ref:	CBC 1133B.7.1.3 and ADA/ABA 403.3

As Built Meas:	39	Quantity:	LF
Description:	Driveway cross/running slope exceeds 2.0%		
As Built Desc:	4.6% cross slope, 9.9% running slope		
Solution:	Provide min. 48" wide level walkway through driveway		
Bar. Severity:	1 Necessary	Cost Estimate:	\$4,875.00
Implementation Priority:	4	Facility Function:	
Implementation Phase:		Implementation Date:	
Official Responsible:			
Notes:

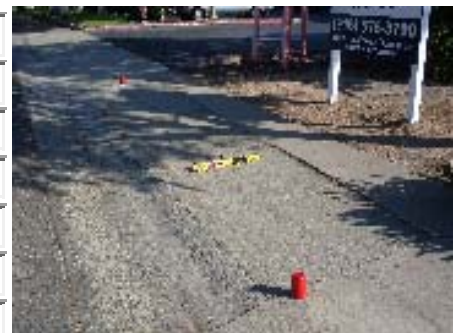
Field Date:	#####	Report Date:	10/19/2010	Barrier #:	1028
Location:	Tupelo Dr - East				
X Coordinate:	-121.31537				
Y Coordinate:	38.70371				
Barrier Area:	Sidewalks				
Barrier Type:	Cross Slope - Existing (4.1% to 4.9%)				
Code Ref:	CBC 1133B.7.1.3 and ADA/ABA 403.3

As Built Meas:	10	Quantity:	LF
Description:	Cross slope exceeds 2.0% (4.1% to 4.9%)		
As Built Desc:	4.6% cross slope		
Solution:	Demolish existing and construct new route		
Bar. Severity:	2 Recommended	Cost Estimate:	\$1,250.00
Implementation Priority:	4	Facility Function:	
Implementation Phase:		Implementation Date:	
Official Responsible:			
Notes:

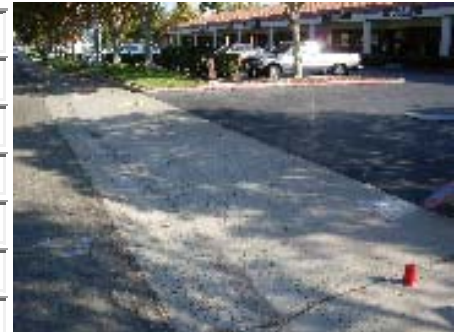
Field Date: ##### Report Date: 10/19/2010 Barrier #: 1029

Barrier Type: Driveway - Existing (5.0% or more)

Description: Driveway cross slope exceeds 2.0% (5.0% or more)

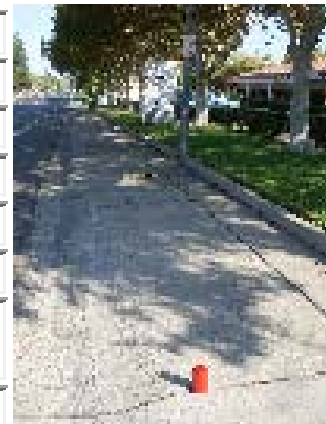
Barrier Type: Cross Slope - Existing (4.1% to 4.9%)

Description: Cross slope exceeds 2.0% (4.1% to 4.9%)

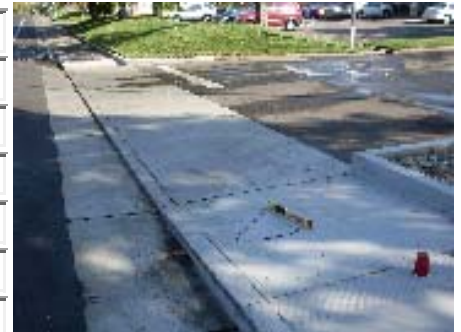
Field Date:	#####	Report Date:	10/19/2010	Barrier #:	1031
Location:	Tupelo Dr - East				
X Coordinate:	-121.31536				
Y Coordinate:	38.70462				
Barrier Area:	Sidewalks				
Barrier Type:	Driveway -12" Grooves Incorrect Application				
Code Ref:	CBC 1127B.5.6

As Built Meas:	0	Quantity:	JOB
Description:	12" grooves required only at curb ramps identified at transition into driveway		
As Built Desc:	12" grooves incorrectly provided where no curb ramp exists		
Solution:	No remediation recommended, until new construction is performed in area		
Bar. Severity:	4 Low Severity	Cost Estimate:	\$0.00
Implementation Priority:	4	Facility Function:	
Implementation Phase:		Implementation Date:	
Official Responsible:			
Notes:	New construction project

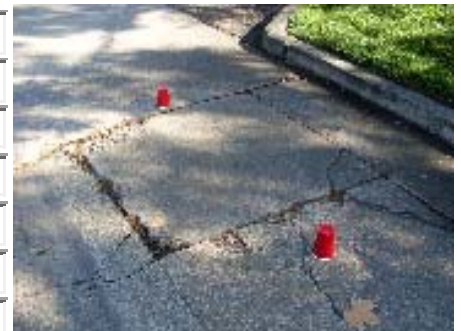
Field Date:	#####	Report Date:	10/19/2010	Barrier #:	1032
Location:	Tupelo Dr - East				
X Coordinate:	-121.31535				
Y Coordinate:	38.70492				
Barrier Area:	Sidewalks				
Barrier Type:	Surface Condition - Damaged				
Code Ref:	CBC 1133B.7.1 and ADA/ABA 302.1

As Built Meas:	8	Quantity:	LF
Description:	Surface is not firm and stable (cracked, broken or loose soil, etc.)		
As Built Desc:	Cracked concrete		
Solution:	Repair surface to make firm and stable		
Bar. Severity:	1 Necessary	Cost Estimate:	\$1,000.00
Implementation Priority:	4	Facility Function:	
Implementation Phase:		Implementation Date:	
Official Responsible:			
Notes:

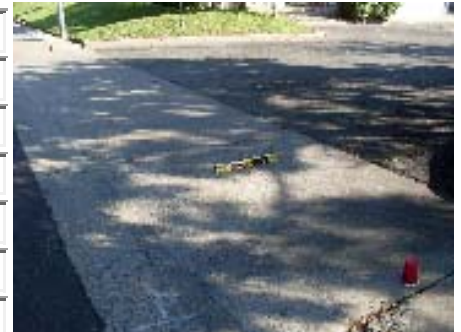
Field Date:	#####	Report Date:	10/19/2010	Barrier #:	1033
Location:	Tupelo Dr - East				
X Coordinate:	-121.31535				
Y Coordinate:	38.70506				
Barrier Area:	Sidewalks				
Barrier Type:	Driveway - Existing (5.0% or more)				
Code Ref:	CBC 1133B.7.1.3 and ADA/ABA 403.3

As Built Meas:	45	Quantity:	LF
Description:	Driveway cross slope exceeds 2.0% (5.0% or more)		
As Built Desc:	5.4% cross slope		
Solution:	Provide min. 48" wide level walkway through driveway		
Bar. Severity:	4 Low Severity	Cost Estimate:	\$5,625.00
Implementation Priority:	4	Facility Function:	
Implementation Phase:		Implementation Date:	
Official Responsible:			
Notes:
