DRAFT ADA TRANSITION PLAN UPDATE
NEIGHBORHOOD AREA 1 NORTHWEST
SEPTEMBER 20, 2011

CITY OF CITRUS HEIGHTS

The Northwest Neighborhood Association

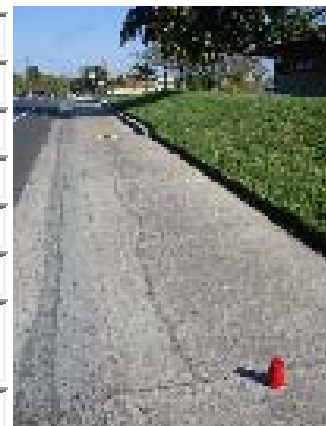
Field Date:	#####	Report Date:	10/19/2010	Barrier #:	1034
Location:	Tupelo Dr - East				
X Coordinate:	-121.31533				
Y Coordinate:	38.70539				
Barrier Area:	Sidewalks				
Barrier Type:	Cross Slope - Existing (5.0% or more)				
Code Ref:	CBC 1133B.7.1.3 and ADA/ABA 403.3

As Built Meas:	99	Quantity:	LF
Description:	Cross slope exceeds 2.0% (5.0% or more)		
As Built Desc:	5.2% cross slope		
Solution:	Demolish existing and construct new route		
Bar. Severity:	1 Necessary	Cost Estimate:	\$12,375.00
Implementation Priority:	4	Facility Function:	
Implementation Phase:		Implementation Date:	
Official Responsible:			
Notes:

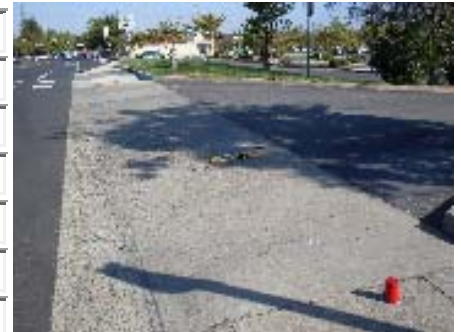
Field Date:	#####	Report Date:	10/19/2010	Barrier #:	1035
Location:	Tupelo Dr - East				
X Coordinate:	-121.31534				
Y Coordinate:	38.70555				
Barrier Area:	Sidewalks				
Barrier Type:	Driveway - New Construction				
Code Ref:	CBC 1133B.7.1.3 and ADA/ABA 403.3

As Built Meas:	49	Quantity:	LF
Description:	Driveway cross/running slope exceeds 2.0%		
As Built Desc:	7.1% cross slope		
Solution:	Provide min. 48" wide level walkway through driveway		
Bar. Severity:	1 Necessary	Cost Estimate:	\$6,125.00
Implementation Priority:	4	Facility Function:	
Implementation Phase:		Implementation Date:	
Official Responsible:			
Notes:

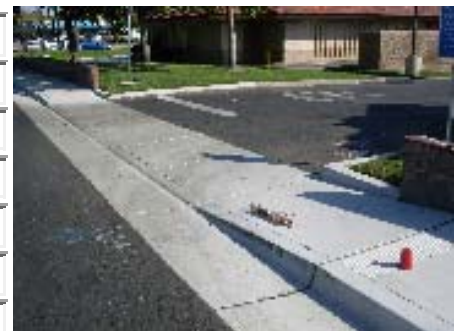
Field Date:	#####	Report Date:	10/19/2010	Barrier #:	1036
Location:	Tupelo Dr - East				
X Coordinate:	-121.3153				
Y Coordinate:	38.70673				
Barrier Area:	Sidewalks				
Barrier Type:	Driveway -12" Grooves Incorrect Application				
Code Ref:	CBC 1127B.5.6

As Built Meas:	0	Quantity:	JOB
Description:	12" grooves required only at curb ramps identified at transition into driveway		
As Built Desc:	12" grooves incorrectly provided where no curb ramp exists		
Solution:	No remediation recommended, until new construction is performed in area		
Bar. Severity:	4 Low Severity	Cost Estimate:	\$0.00
Implementation Priority:	4	Facility Function:	
Implementation Phase:		Implementation Date:	
Official Responsible:			
Notes:	New construction project

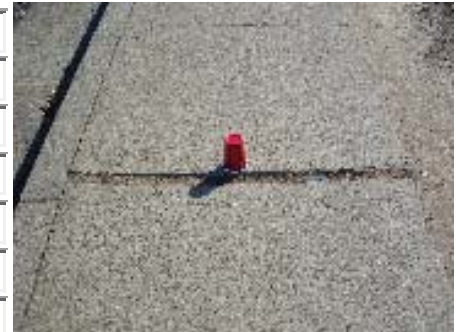
Field Date:	#####	Report Date:	10/19/2010	Barrier #:	1037
Location:	Antelope Rd - South				
X Coordinate:	-121.3119				
Y Coordinate:	38.70723				
Barrier Area:	Sidewalks				
Barrier Type:	Surface Condition - Damaged				
Code Ref:	CBC 1133B.7.1 and ADA/ABA 302.1

As Built Meas:	4	Quantity:	LF
Description:	Surface is not firm and stable (cracked, broken or loose soil, etc.)		
As Built Desc:	Cracked concrete		
Solution:	Repair surface to make firm and stable		
Bar. Severity:	1 Necessary	Cost Estimate:	\$500.00
Implementation Priority:	1	Facility Function:	
Implementation Phase:		Implementation Date:	
Official Responsible:			
Notes:

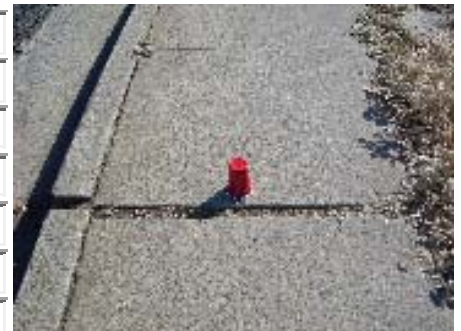
Field Date:	#####	Report Date:	10/19/2010	Barrier #:	1038
Location:	Antelope Rd - South				
X Coordinate:	-121.30891				
Y Coordinate:	38.70727				
Barrier Area:	Sidewalks				
Barrier Type:	Surface Condition - Damaged				
Code Ref:	CBC 1133B.7.1 and ADA/ABA 302.1

As Built Meas:	4	Quantity:	LF
Description:	Surface is not firm and stable (cracked, broken or loose soil, etc.)		
As Built Desc:	Cracked concrete		
Solution:	Repair surface to make firm and stable		
Bar. Severity:	1 Necessary	Cost Estimate:	\$500.00
Implementation Priority:	1	Facility Function:	
Implementation Phase:		Implementation Date:	
Official Responsible:			
Notes:

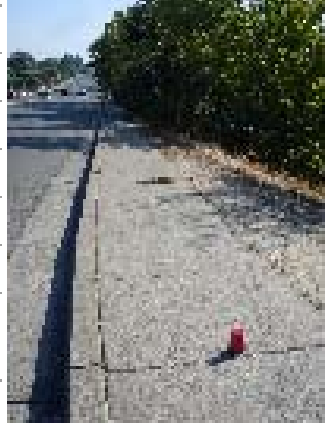
Field Date:	#####	Report Date:	10/19/2010	Barrier #:	1039

Location:	Antelope Rd - South					
X Coordinate:	-121.30764					
Y Coordinate:	38.70726					
Barrier Area:	Sidewalks					
Barrier Type:	Cross Slope - Existing (5.0% or more)					
Code Ref:	CBC 1133B.7.1.3 and ADA/ABA 403.3					
As Built Meas:	40	Quantity:	LF

Description:	Cross slope exceeds 2.0% (5.0% or more)					
As Built Desc:	5.1% cross slope					
Solution:	Demolish existing and construct new route					
Bar. Severity:	1 Necessary	Cost Estimate:	\$5,000.00	Status:		
Implementation Priority:	1	Facility Function:				
Implementation Phase:		Implementation Date:				
Official Responsible:						
Notes:

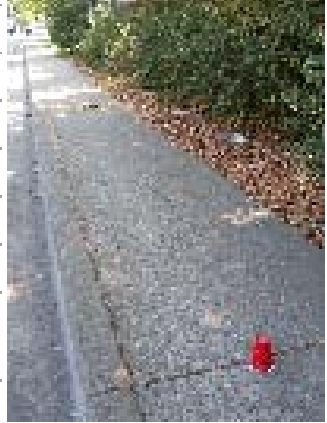
Field Date:	#####	Report Date:	10/19/2010	Barrier #:	1040A

Location:	Antelope Rd - South					
X Coordinate:	-121.30675					
Y Coordinate:	38.70727					
Barrier Area:	Sidewalks					
Barrier Type:	Cross Slope - Existing (5.0% or more)					
Code Ref:	CBC 1133B.7.1.3 and ADA/ABA 403.3					
As Built Meas:	214	Quantity:	LF

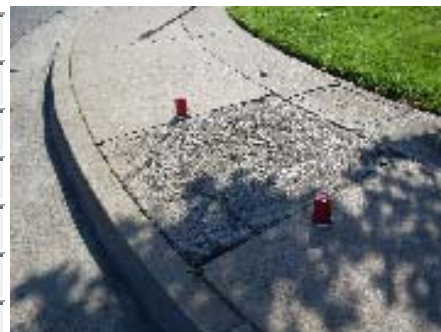
Barrier Type: Surface Condition - Damaged

Description: Surface is not firm and stable (cracked, broken or loose soil, etc.)

As Built Desc: Cracked concrete

Solution: Repair surface to make firm and stable
