SZS CONSULTING GROUP

DRAFT ADA TRANSITION PLAN UPDATE
NEIGHBORHOOD AREA 3 CHANT
SEPTEMBER 20, 2011

CITY OF CITRUS HEIGHTS

Citrus Heights Area Three (CHANT)

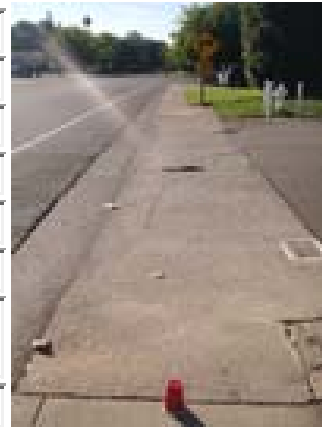
Barrier Type: Driveway - Existing (5.0% or more)

Code Ref: CBC 1133B.7.1.3 and ADA/ABA 403.3

As Built Meas: 40 Quantity: LF

Description: Driveway cross slope exceeds 2.0% (5.0% or more)

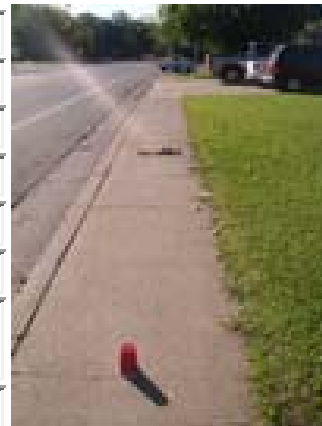
Barrier Type: Cross Slope - Existing (4.1% to 4.9%)

Code Ref: CBC 1133B.7.1.3 and ADA/ABA 403.3

As Built Meas: 30 Quantity: LF

Description: Cross slope exceeds 2.0% (4.1% to 4.9%)

Bar. Severity: 2 Recommended Cost Estimate: \$3,750.00 Status:

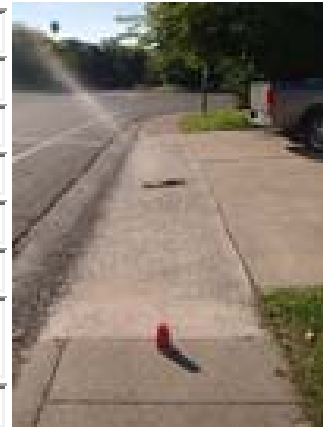
Barrier Type: Driveway - Existing (5.0% or more)

Code Ref: CBC 1133B.7.1.3 and ADA/ABA 403.3

As Built Meas: 41 Quantity: LF

Description: Driveway cross slope exceeds 2.0% (5.0% or more)

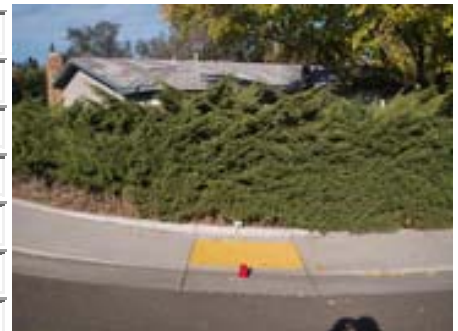
Barrier Type: 12" Grooves - New Construction

Code Ref: CBC 1127B.5.6

As Built Meas: 1 Quantity: EACH

Description: 12" grooves at top of curb ramp are not level (>5.0%)

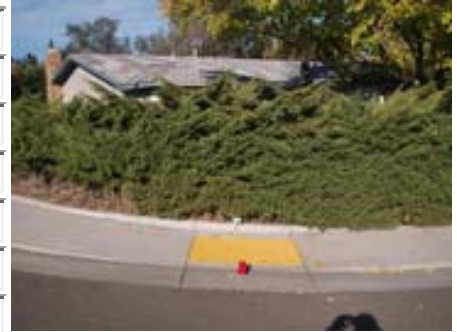
Barrier Type: Parallel Ramp Landing - New Construction

Code Ref: CBC 1127B.5.4 and ADA/ABA 406.4

As Built Meas: 1 Quantity: EACH

Description: Curb ramp landing or pan not level (3.1% to 4.0%)

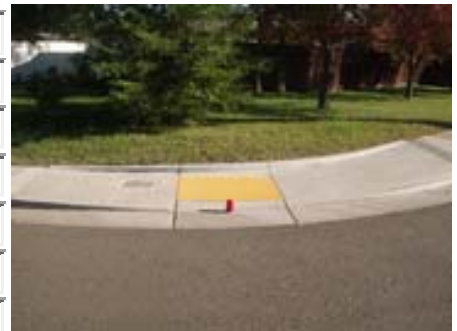
Barrier Type: Gutter Slope - New Construction

Code Ref: CBC 1127B.5.3 and ADA/ABA 406.2

As Built Meas: 6 Quantity: SF

Description: Gutter slope exceeds 5.0% (5.1% - 5.8%)

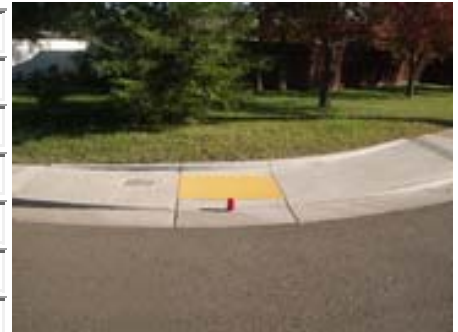
Barrier Type: 12" Grooves - New Construction

Code Ref: CBC 1127B.5.6

As Built Meas: 1 Quantity: EACH

Description: 12" grooves at top of curb ramp are not level (4.1% to 4.9%)

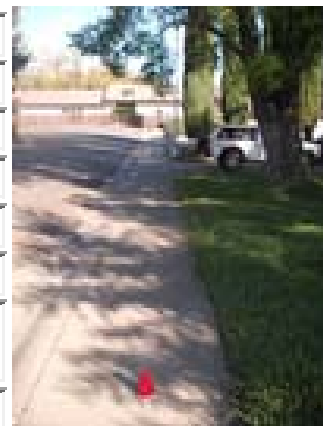
Barrier Type: Cross Slope - Existing (3.1% to 4.0%)

Code Ref: CBC 1133B.7.1.3 and ADA/ABA 403.3

As Built Meas: 113 Quantity: LF

Description: Cross slope exceeds 2.0% (3.1% to 4.0%)

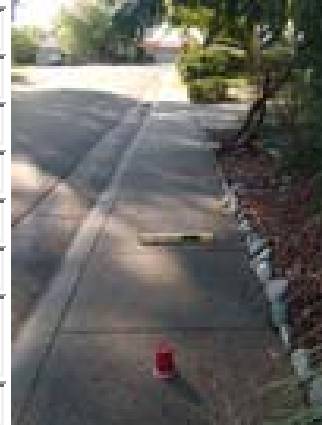
Barrier Type: Cross Slope - Existing (5.0% or more)

Code Ref: CBC 1133B.7.1.3 and ADA/ABA 403.3

As Built Meas: 86 Quantity: LF

Description: Cross slope exceeds 2.0% (5.0% or more)

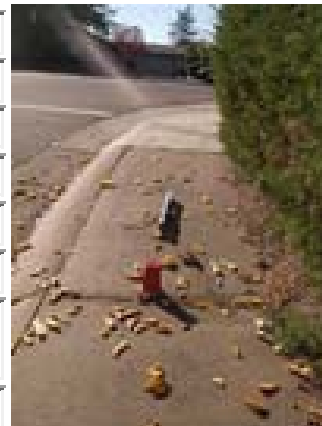
Barrier Type: Running Slope (Existing)

Code Ref: CBC 1133B.7.3 and ADA/ABA 403.3

As Built Meas: 8 Quantity: LF

Description: Running slope exceeds 5.0%

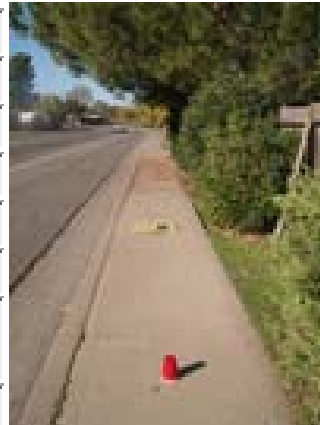
Barrier Type: Cross Slope - Existing (5.0% or more)

Code Ref: CBC 1133B.7.1.3 and ADA/ABA 403.3

As Built Meas: 102 Quantity: LF

Description: Cross slope exceeds 2.0% (5.0% or more)

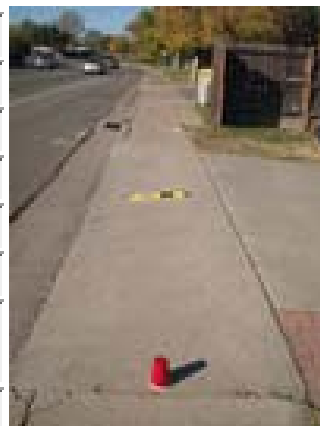
Barrier Type: Driveway - Existing (5.0% or more)

Code Ref: CBC 1133B.7.1.3 and ADA/ABA 403.3

As Built Meas: 21 Quantity: LF

Description: Driveway cross slope exceeds 2.0% (5.0% or more)

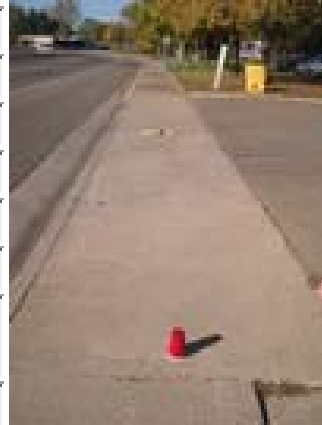
Barrier Type: Driveway - Existing (5.0% or more)

Code Ref: CBC 1133B.7.1.3 and ADA/ABA 403.3

As Built Meas: 46 Quantity: LF

Description: Driveway cross slope exceeds 2.0% (5.0% or more)

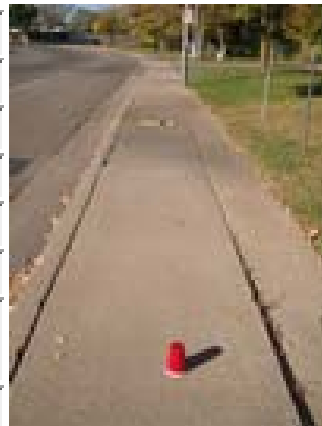
Barrier Type: Cross Slope - Existing (4.1% to 4.9%)

Code Ref: CBC 1133B.7.1.3 and ADA/ABA 403.3

As Built Meas: 73 Quantity: LF

Description: Cross slope exceeds 2.0% (4.1% to 4.9%)

Bar. Severity: 2 Recommended Cost Estimate: \$9,125.00 Status:

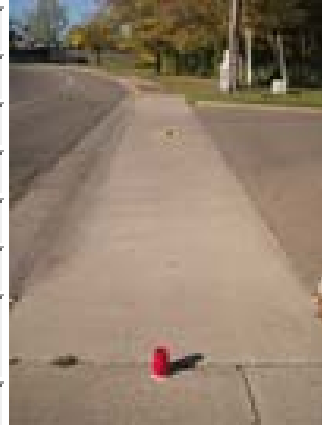
Barrier Type: Driveway - Existing (5.0% or more)

Code Ref: CBC 1133B.7.1.3 and ADA/ABA 403.3

As Built Meas: 50 Quantity: LF

Description: Driveway cross slope exceeds 2.0% (5.0% or more)

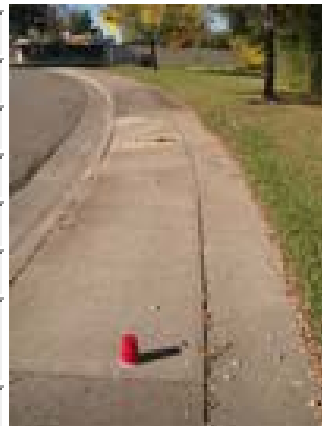
Barrier Type: Cross Slope - Existing (5.0% or more)

Code Ref: CBC 1133B.7.1.3 and ADA/ABA 403.3

As Built Meas: 64 Quantity: LF

Description: Cross slope exceeds 2.0% (5.0% or more)

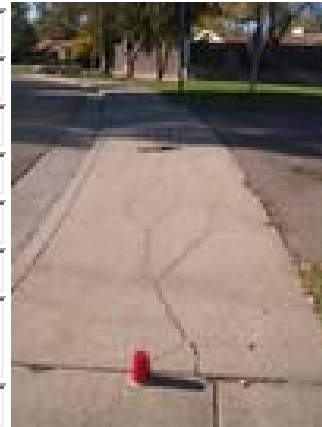
Barrier Type: Driveway - Existing (5.0% or more)

Code Ref: CBC 1133B.7.1.3 and ADA/ABA 403.3

As Built Meas: 36 Quantity: LF

Description: Driveway cross slope exceeds 2.0% (5.0% or more)

As Built Desc: 9.8% cross slope at cracked concrete

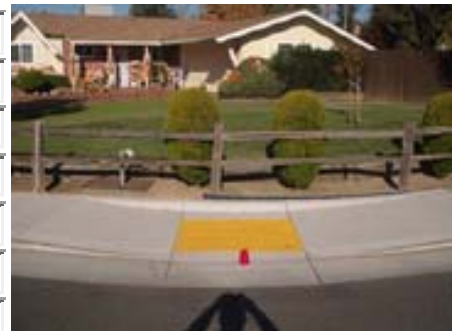
Barrier Type: 12" Grooves - New Construction

Code Ref: CBC 1127B.5.6

As Built Meas: 1 Quantity: EACH

Description: 12" grooves at top of curb ramp are not level (>5.0%)

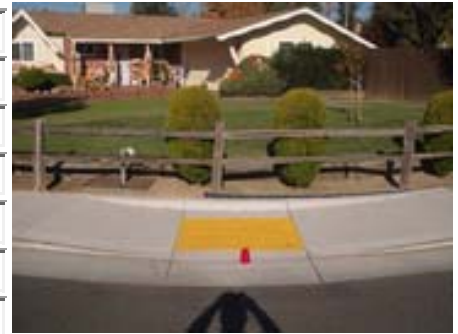
Barrier Type: Gutter Slope - New Construction

Code Ref: CBC 1127B.5.3 and ADA/ABA 406.2

As Built Meas: 6 Quantity: SF

Description: Gutter slope exceeds 5.0% (5.1% - 5.8%)

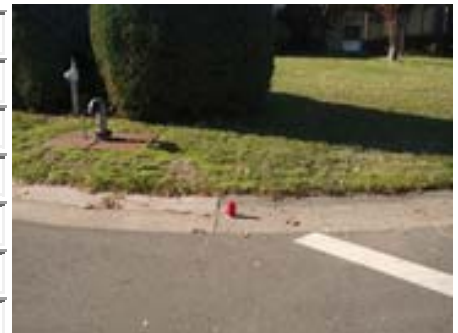
Barrier Type: Detectable Warnings - Truncated Domes

Code Ref: CBC 1127B.5.3

As Built Meas: 1 Quantity: EACH

Description: No truncated domes provided at transition into roadway

Bar. Severity: 2 Recommended Cost Estimate: \$1,400.00 Status:

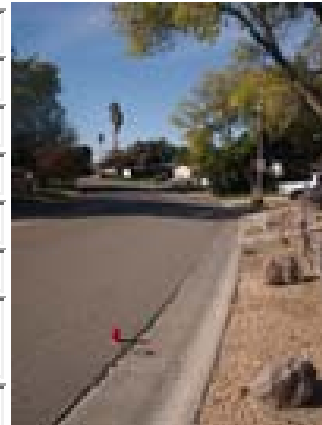
Barrier Type: No sidewalk

Code Ref: CBC 1127B.1 and ADA/ABA 206.2.1

As Built Meas: 2968 Quantity: LF

Description: No pedestrian route provided

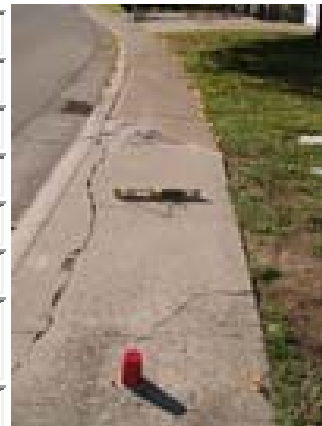
Barrier Type: Cross Slope - Existing (5.0% or more)

Code Ref: CBC 1133B.7.1.3 and ADA/ABA 403.3

As Built Meas: 270 Quantity: LF

Description: Cross slope exceeds 2.0% (5.0% or more)

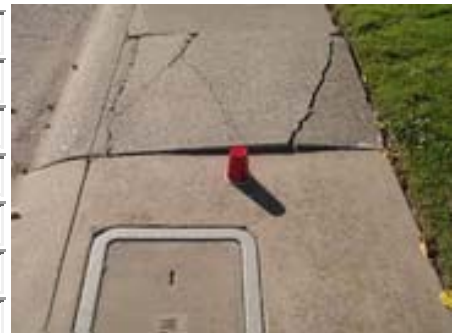
Barrier Type: Abrupt Change in Level - > 1/2"

Code Ref: CBC 1133B.7.1 and ADA/ABA 303.3

As Built Meas: 4 Quantity: LF

Description: Change in level greater than 1/2"

Solution: Grind or repair sidewalk to remove trip hazard

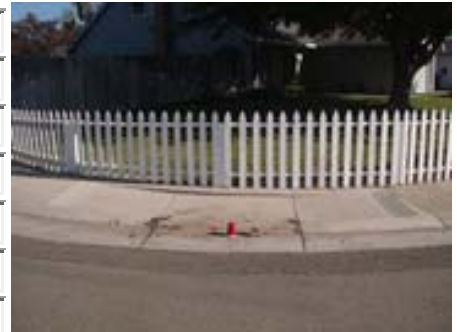
Barrier Type: 12" Grooves - Existing (3.1% to 4.0%)

Code Ref: CBC 1127B.5.6

As Built Meas: 1 Quantity: EACH

Description: 12" grooves at top of curb ramp are not level (3.1% to 4.0%)

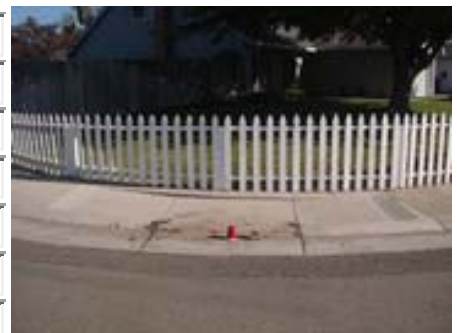
Barrier Type: Detectable Warnings - Truncated Domes

Code Ref: CBC 1127B.5.7 and ADA/ABA 705.1.3

As Built Meas: 1 Quantity: EACH

Description: No truncated domes provided at curb ramp

Bar. Severity: 2 Recommended Cost Estimate: \$0.00 Status:

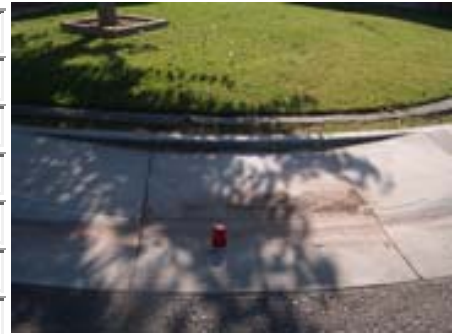
Barrier Type: Detectable Warnings - Truncated Domes

Code Ref: CBC 1127B.5.7 and ADA/ABA 705.1.3

As Built Meas: 1 Quantity: EACH

Description: No truncated domes provided at curb ramp

Bar. Severity: 2 Recommended Cost Estimate: \$1,400.00 Status:

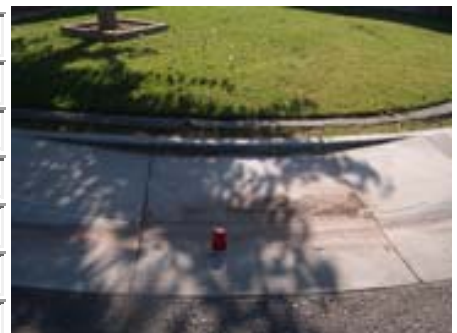
Barrier Type: Gutter Slope - Existing (5.1% - 5.8%)

Code Ref: CBC 1127B.5.3 and ADA/ABA 406.2

As Built Meas: 6 Quantity: SF

Description: Gutter slope exceeds 5.0% (5.1% - 5.8%)

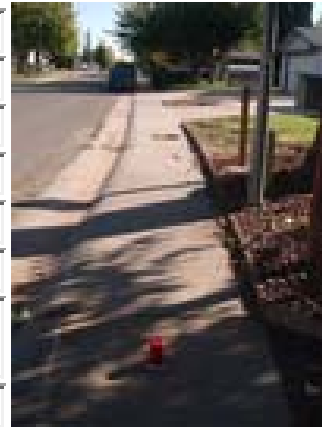
Barrier Type: Cross Slope - Existing (5.0% or more)

Code Ref: CBC 1133B.7.1.3 and ADA/ABA 403.3

As Built Meas: 910 Quantity: LF

Description: Cross slope exceeds 2.0% (5.0% or more)

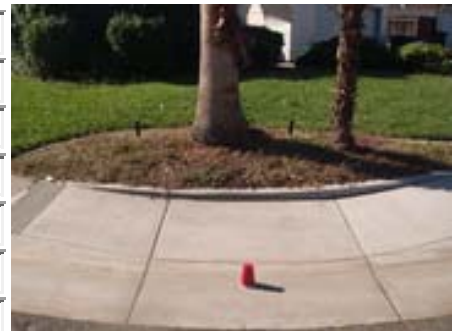
Barrier Type: 12" Grooves - Existing (3.1% to 4.0%)

Code Ref: CBC 1127B.5.6

As Built Meas: 1 Quantity: EACH

Description: 12" grooves at top of curb ramp are not level (3.1% to 4.0%)

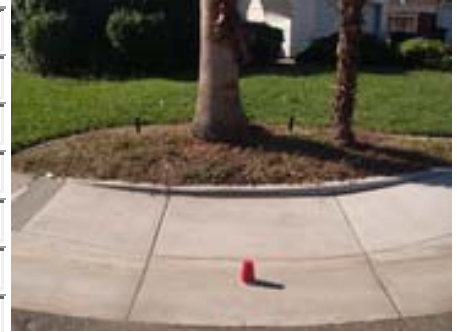
Barrier Type: Detectable Warnings - Truncated Domes

Code Ref: CBC 1127B.5.7 and ADA/ABA 705.1.3

As Built Meas: 1 Quantity: EACH

Description: No truncated domes provided at curb ramp

Bar. Severity: 2 Recommended Cost Estimate: \$0.00 Status:

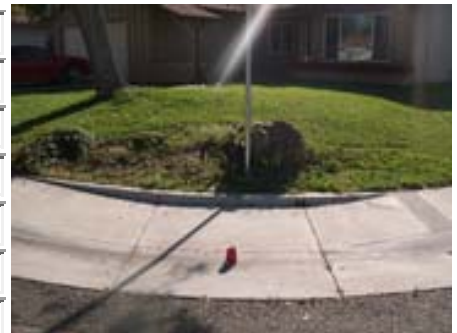
Barrier Type: 12" Grooves - Existing (3.1% to 4.0%)

Code Ref: CBC 1127B.5.6

As Built Meas: 1 Quantity: EACH

Description: 12" grooves at top of curb ramp are not level (3.1% to 4.0%)

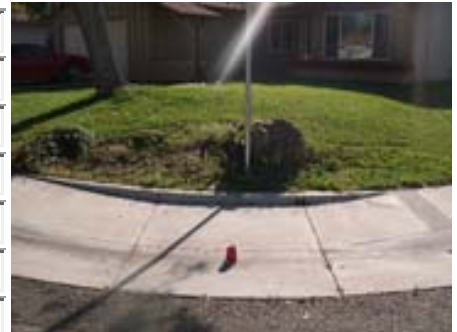
Barrier Type: Detectable Warnings - Truncated Domes

Code Ref: CBC 1127B.5.7 and ADA/ABA 705.1.3

As Built Meas: 1 Quantity: EACH

Description: No truncated domes provided at curb ramp

Bar. Severity: 2 Recommended Cost Estimate: \$0.00 Status:

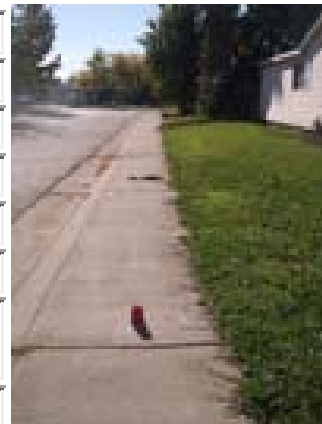
Barrier Type: Cross Slope - Existing (5.0% or more)

Code Ref: CBC 1133B.7.1.3 and ADA/ABA 403.3

As Built Meas: 186 Quantity: LF

Description: Cross slope exceeds 2.0% (5.0% or more)

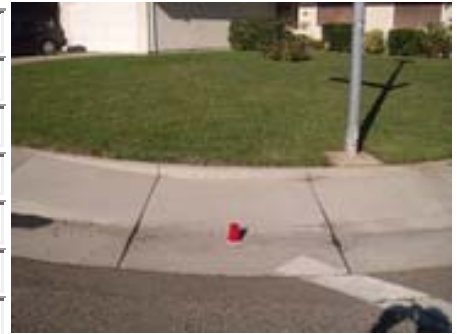
Barrier Type: Detectable Warnings - Truncated Domes

Code Ref: CBC 1127B.5.7 and ADA/ABA 705.1.3

As Built Meas: 1 Quantity: EACH

Description: No truncated domes provided at curb ramp

Bar. Severity: 2 Recommended Cost Estimate: \$1,400.00 Status:

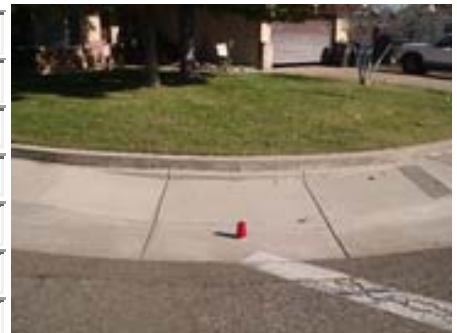
Barrier Type: Detectable Warnings - Truncated Domes

Description: No truncated domes provided at curb ramp

Bar. Severity: 2 Recommended Cost Estimate: \$1,400.00 Status:

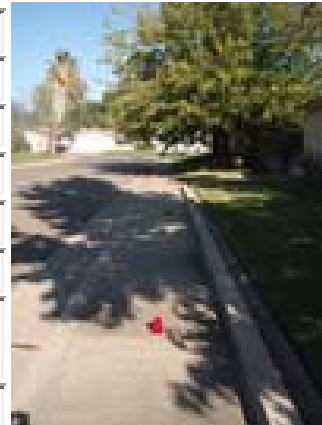
Barrier Type: Cross Slope - Existing (3.1% to 4.0%)

Description: Cross slope exceeds 2.0% (3.1% to 4.0%)

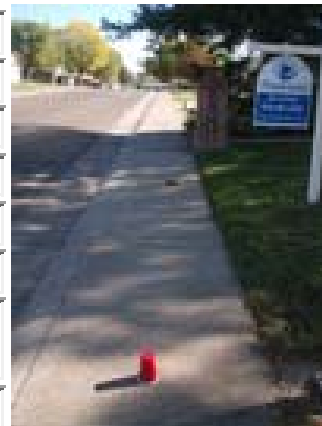
Barrier Type: Cross Slope - Existing (5.0% or more)

Description: Cross slope exceeds 2.0% (5.0% or more)

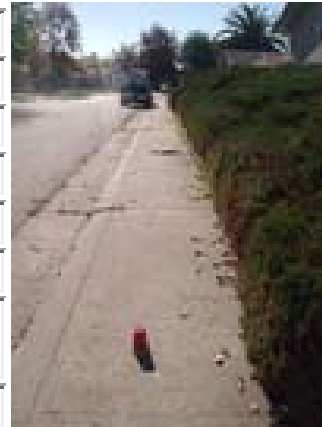
Barrier Type: Cross Slope - Existing (4.1% to 4.9%)

Description: Cross slope exceeds 2.0% (4.1% to 4.9%)

Bar. Severity: 2 Recommended Cost Estimate: \$23,500.00 Status:

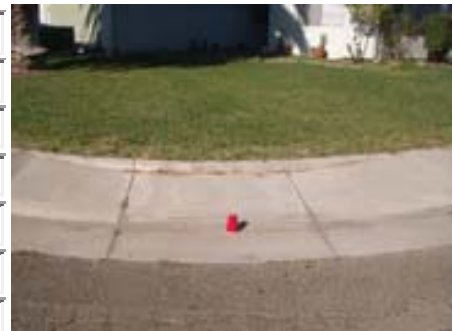
Barrier Type: 12" Grooves - Existing (4.1% to 4.9%)

Description: 12" grooves at top of curb ramp are not level (4.1% to 4.9%)

Bar. Severity: 2 Recommended Cost Estimate: \$2,500.00 Status:

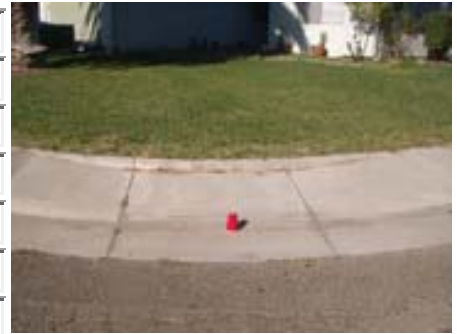
Barrier Type: Detectable Warnings - Truncated Domes

Description: No truncated domes provided at curb ramp

Bar. Severity: 2 Recommended Cost Estimate: \$0.00 Status:

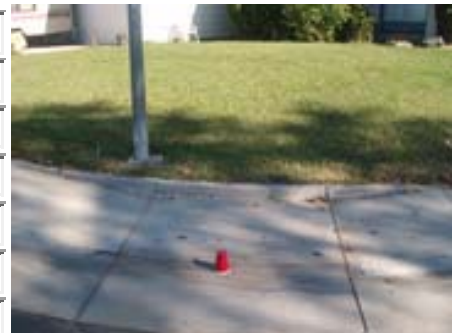
Barrier Type: 12" Grooves - Existing (3.1% to 4.0%)

Description: 12" grooves at top of curb ramp are not level (3.1% to 4.0%)

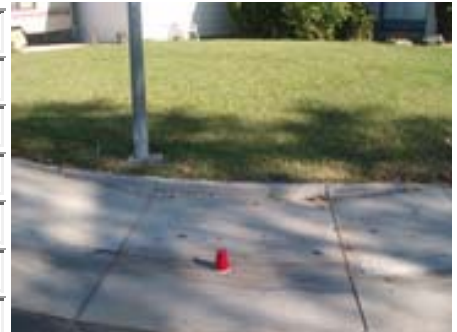
Barrier Type: Detectable Warnings - Truncated Domes

Description: No truncated domes provided at curb ramp

Bar. Severity: 2 Recommended Cost Estimate: \$0.00 Status:

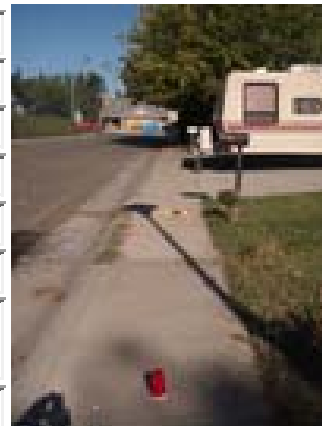
Barrier Type: Cross Slope - Existing (4.1% to 4.9%)

Description: Cross slope exceeds 2.0% (4.1% to 4.9%)

Bar. Severity: 2 Recommended Cost Estimate: \$27,125.00 Status:

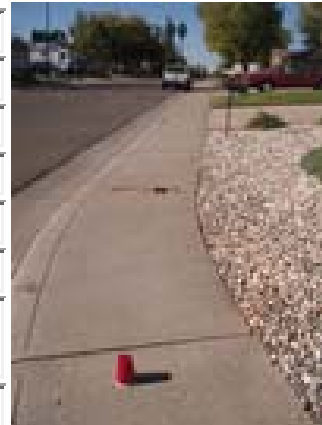
Barrier Type: Cross Slope - Existing (5.0% or more)

Description: Cross slope exceeds 2.0% (5.0% or more)

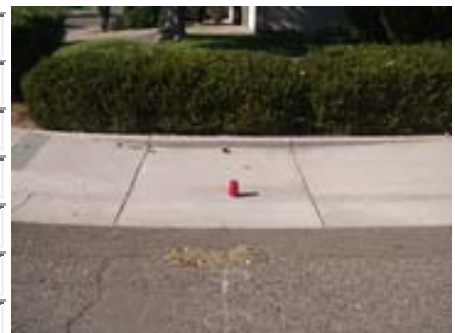
Barrier Type: Detectable Warnings - Truncated Domes

Description: No truncated domes provided at curb ramp

Bar. Severity: 2 Recommended Cost Estimate: \$1,400.00 Status:

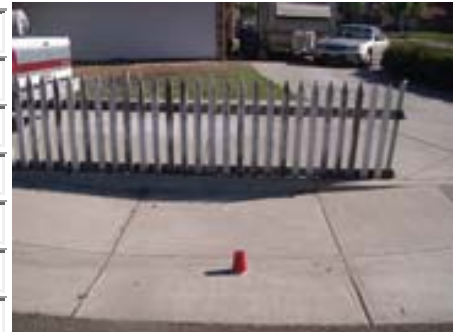
Barrier Type: Detectable Warnings - Truncated Domes

Description: No truncated domes provided at curb ramp

Bar. Severity: 2 Recommended Cost Estimate: \$1,400.00 Status:

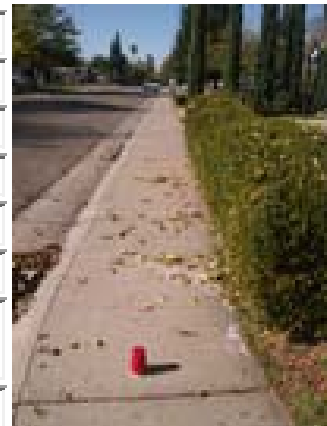
Barrier Type: Cross Slope - Existing (5.0% or more)

Description: Cross slope exceeds 2.0% (5.0% or more)

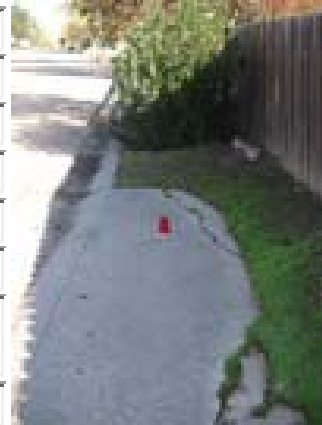
Barrier Type: No Sidewalk - No Barricade

Description: No barricade provided where sidewalk ends in hazardous location

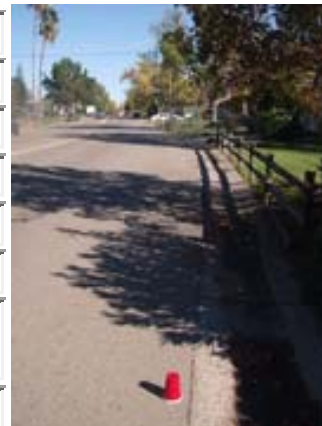
Barrier Type: No sidewalk

Description: No pedestrian route provided

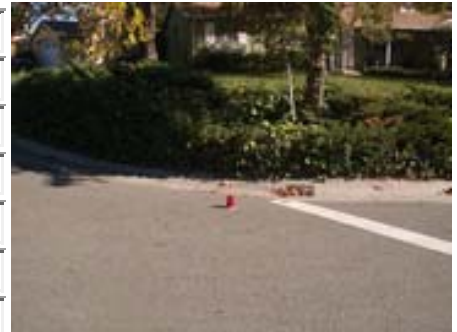
Barrier Type: Detectable Warnings - Truncated Domes

Description: No truncated domes provided at transition into roadway

Bar. Severity: 2 Recommended Cost Estimate: \$1,400.00 Status:

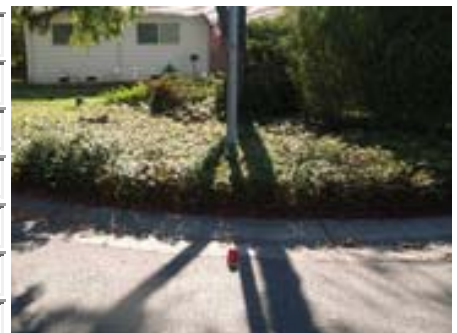
Barrier Type: Detectable Warnings - Truncated Domes

Description: No truncated domes provided at transition into roadway

Bar. Severity: 2 Recommended Cost Estimate: \$1,400.00 Status:

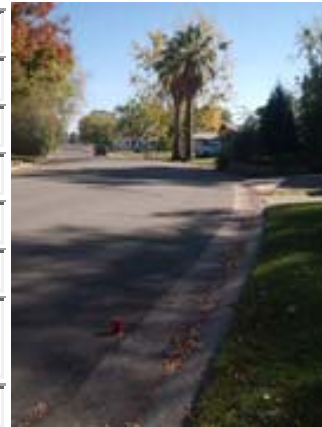
Barrier Type: No sidewalk

Description: No pedestrian route provided

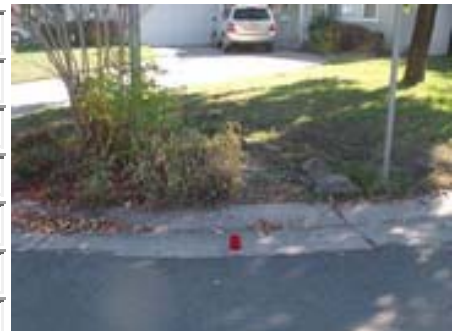
Barrier Type: Detectable Warnings - Truncated Domes

Description: No truncated domes provided at transition into roadway

Bar. Severity: 2 Recommended Cost Estimate: \$1,400.00 Status:

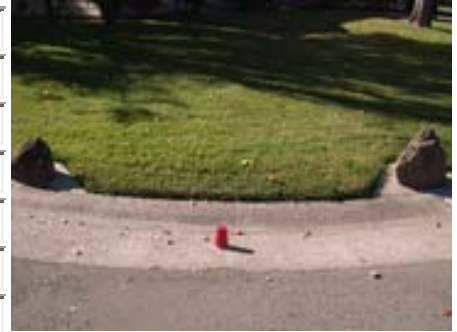
Barrier Type: Detectable Warnings - Truncated Domes

Description: No truncated domes provided at transition into roadway

Bar. Severity: 2 Recommended Cost Estimate: \$1,400.00 Status:

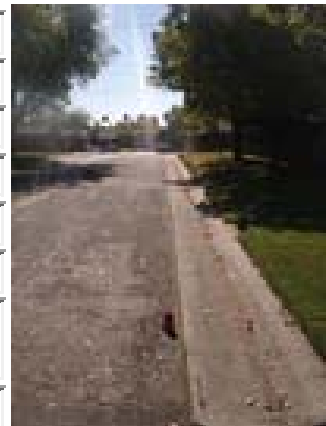
Barrier Type: No sidewalk

Description: No pedestrian route provided

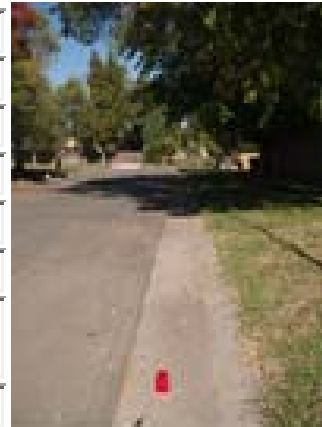
Barrier Type: No sidewalk

Description: No pedestrian route provided

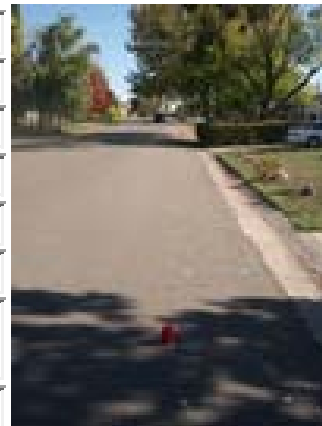
Barrier Type: No sidewalk

Description: No pedestrian route provided

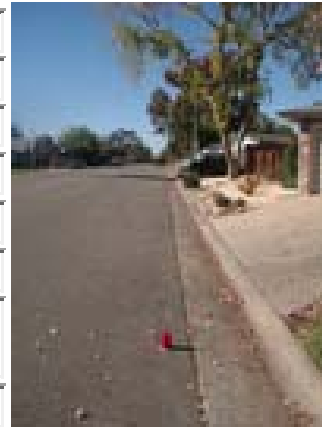
Barrier Type: No sidewalk

Description: No pedestrian route provided

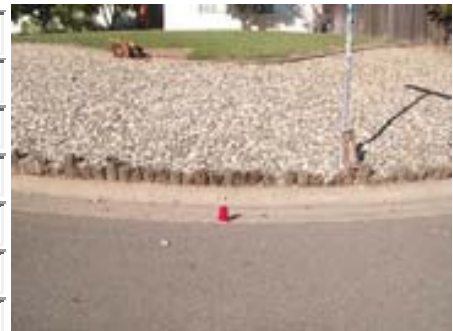
Barrier Type: Detectable Warnings - Truncated Domes

Description: No truncated domes provided at transition into roadway

Bar. Severity: 2 Recommended Cost Estimate: \$1,400.00 Status:

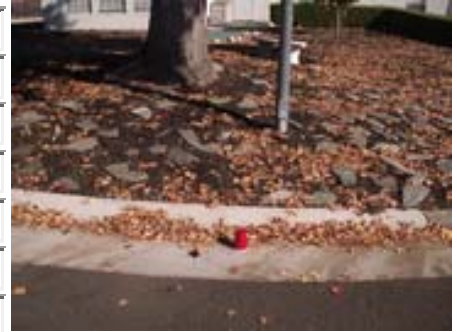
Barrier Type: Detectable Warnings - Truncated Domes

Description: No truncated domes provided at transition into roadway

Bar. Severity: 2 Recommended Cost Estimate: \$1,400.00 Status:

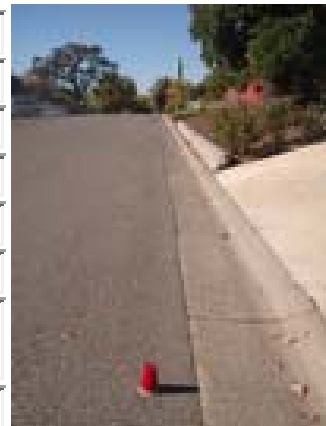
Barrier Type: No sidewalk

Description: No pedestrian route provided

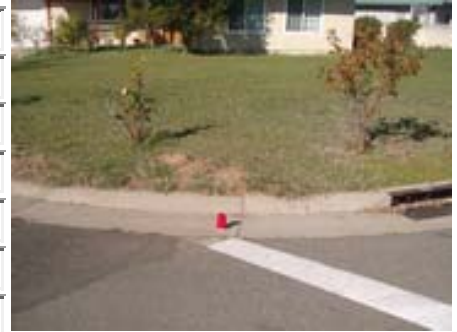
Barrier Type: Detectable Warnings - Truncated Domes

Description: No truncated domes provided at transition into roadway

Bar. Severity: 2 Recommended Cost Estimate: \$1,400.00 Status:

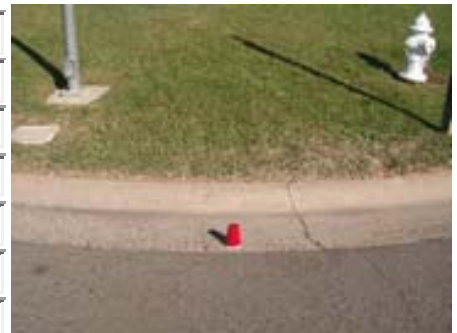
Barrier Type: Detectable Warnings - Truncated Domes

Description: No truncated domes provided at transition into roadway

Bar. Severity: 2 Recommended Cost Estimate: \$1,400.00 Status:

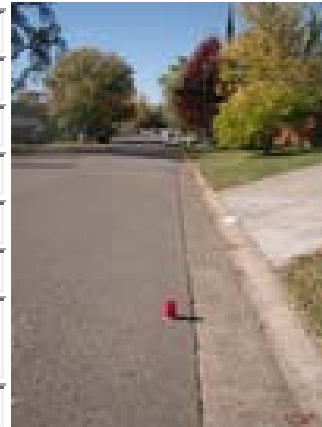
Field Date:	11/12/2010	Report Date:	11/12/2010	Barrier #:	2355
Location:	Skylane Dr - North				
X Coordinate:	-121.31138				
Y Coordinate:	38.70063				
Barrier Area:	Sidewalks				
Barrier Type:	No sidewalk				
Code Ref:	CBC 1127B.1 and ADA/ABA 206.2.1

As Built Meas:	246	Quantity:	LF	
Description:	No pedestrian route provided			
As Built Desc:	No sidewalk provided			
Solution:	Construct new firm and stable pedestrian route			
Bar. Severity:	1 Necessary	Cost Estimate:	\$24,600.00	Status:
Implementation Priority:	4	Facility Function:		
Implementation Phase:		Implementation Date:		
Official Responsible:

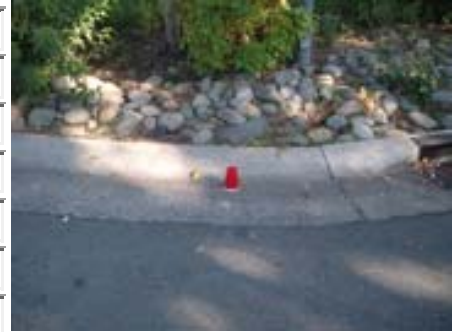
Barrier Type: Detectable Warnings - Truncated Domes

Description: No truncated domes provided at transition into roadway

Bar. Severity: 2 Recommended Cost Estimate: \$1,400.00 Status:

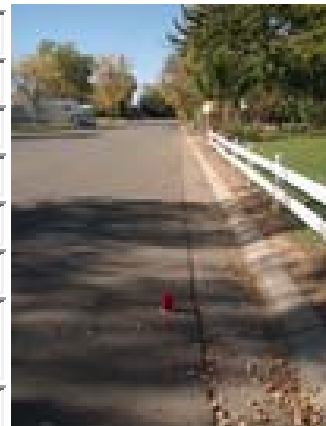
Barrier Type: No sidewalk

Description: No pedestrian route provided

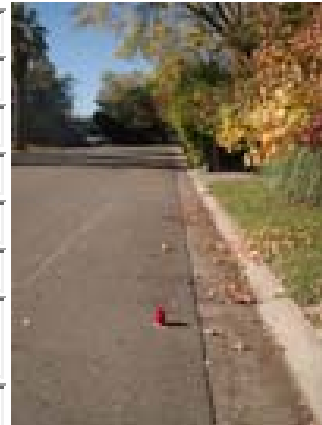
Barrier Type: No sidewalk

Description: No pedestrian route provided

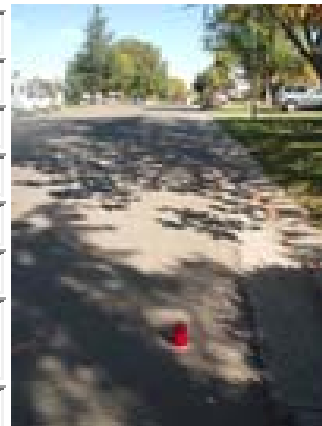
Barrier Type: No sidewalk

Description: No pedestrian route provided

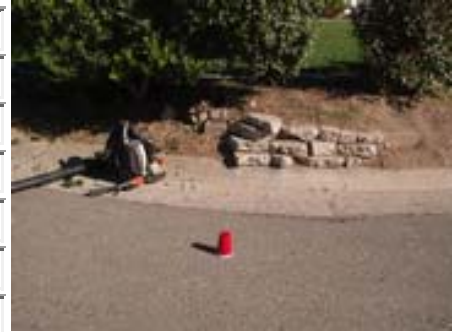
Barrier Type: Detectable Warnings - Truncated Domes

Description: No truncated domes provided at transition into roadway

Bar. Severity: 2 Recommended Cost Estimate: \$1,400.00 Status:

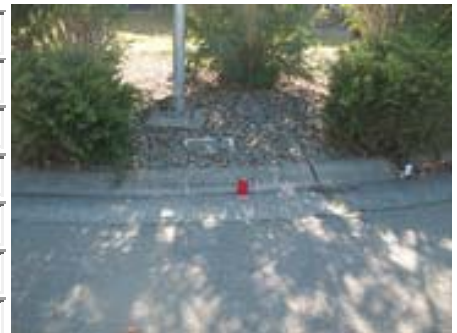
Barrier Type: Detectable Warnings - Truncated Domes

Description: No truncated domes provided at transition into roadway

Bar. Severity: 2 Recommended Cost Estimate: \$1,400.00 Status:

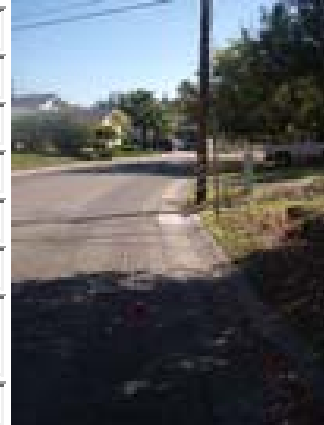
Barrier Type: No sidewalk

Description: No pedestrian route provided

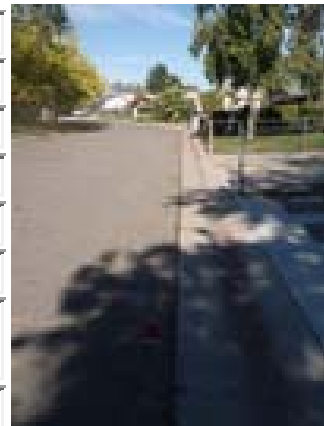
Barrier Type: No sidewalk

Description: No pedestrian route provided

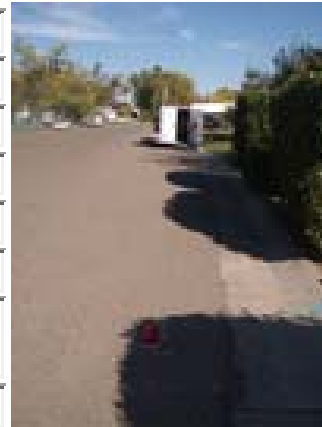
Barrier Type: No sidewalk

Description: No pedestrian route provided

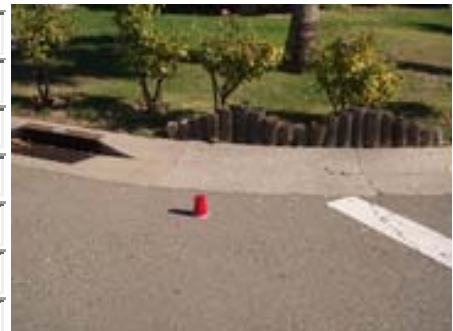
Barrier Type: Detectable Warnings - Truncated Domes

Description: No truncated domes provided at transition into roadway

Bar. Severity: 2 Recommended Cost Estimate: \$1,400.00 Status:

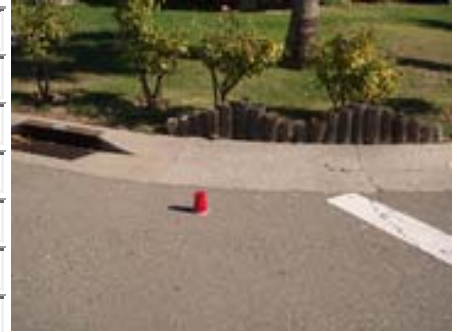
Barrier Type: Detectable Warnings - Truncated Domes

Code Ref: CBC 1127B.5.3

As Built Meas: 1 Quantity: EACH

Description: No truncated domes provided at transition into roadway

Bar. Severity: 2 Recommended Cost Estimate: \$1,400.00 Status:

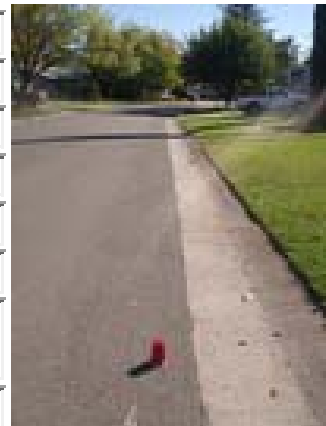
Barrier Type: No sidewalk

Code Ref: CBC 1127B.1 and ADA/ABA 206.2.1

As Built Meas: 874 Quantity: LF

Description: No pedestrian route provided

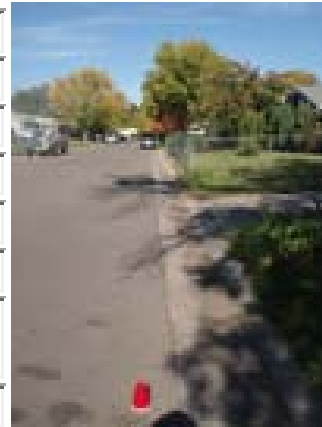
Barrier Type: No sidewalk

Code Ref: CBC 1127B.1 and ADA/ABA 206.2.1

As Built Meas: 879 Quantity: LF

Description: No pedestrian route provided

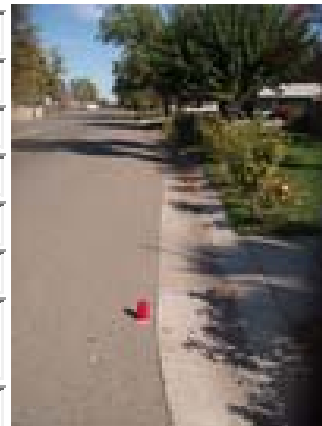
Barrier Type: No sidewalk

Code Ref: CBC 1127B.1 and ADA/ABA 206.2.1

As Built Meas: 237 Quantity: LF

Description: No pedestrian route provided

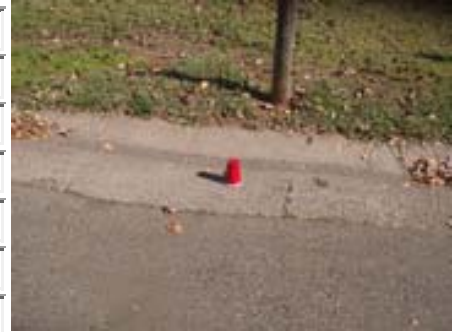
Barrier Type: Detectable Warnings - Truncated Domes

Code Ref: CBC 1127B.5.3

As Built Meas: 1 Quantity: EACH

Description: No truncated domes provided at transition into roadway

Bar. Severity: 2 Recommended Cost Estimate: \$1,400.00 Status:

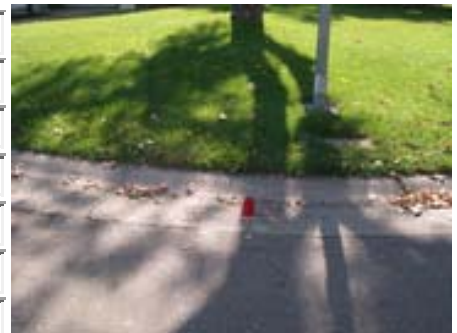
Barrier Type: Detectable Warnings - Truncated Domes

Code Ref: CBC 1127B.5.3

As Built Meas: 1 Quantity: EACH

Description: No truncated domes provided at transition into roadway

Bar. Severity: 2 Recommended Cost Estimate: \$1,400.00 Status:

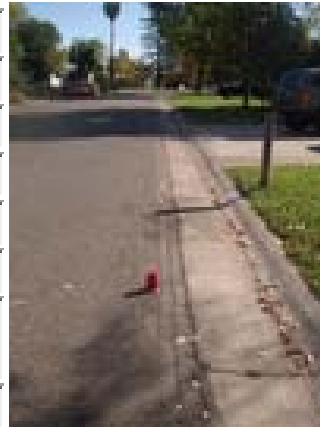
Barrier Type: No sidewalk

Code Ref: CBC 1127B.1 and ADA/ABA 206.2.1

As Built Meas: 1153 Quantity: LF

Description: No pedestrian route provided

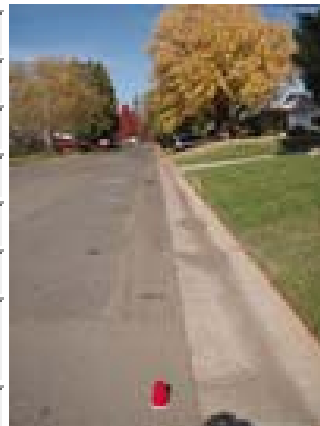
Barrier Type: No sidewalk

Code Ref: CBC 1127B.1 and ADA/ABA 206.2.1

As Built Meas: 1172 Quantity: LF

Description: No pedestrian route provided

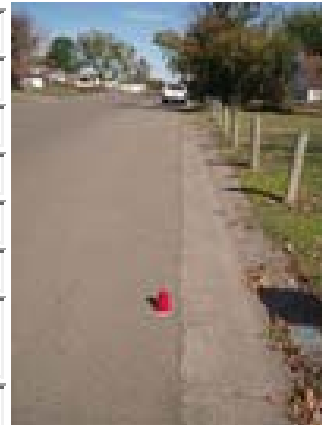
Barrier Type: No sidewalk

Code Ref: CBC 1127B.1 and ADA/ABA 206.2.1

As Built Meas: 246 Quantity: LF

Description: No pedestrian route provided

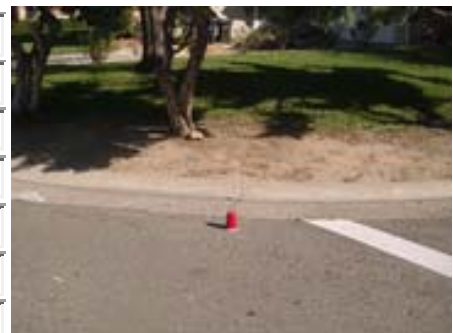
Barrier Type: Detectable Warnings - Truncated Domes

Code Ref: CBC 1127B.5.3

As Built Meas: 1 Quantity: EACH

Description: No truncated domes provided at transition into roadway

Bar. Severity: 2 Recommended Cost Estimate: \$1,400.00 Status:

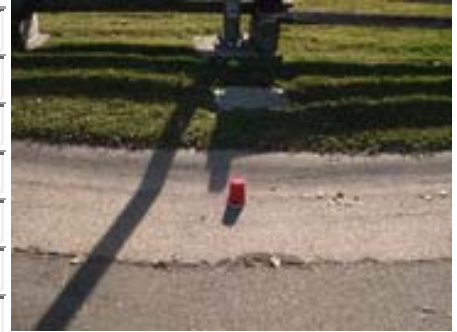
Barrier Type: Detectable Warnings - Truncated Domes

Code Ref: CBC 1127B.5.3

As Built Meas: 1 Quantity: EACH

Description: No truncated domes provided at transition into roadway

Bar. Severity: 2 Recommended Cost Estimate: \$1,400.00 Status:

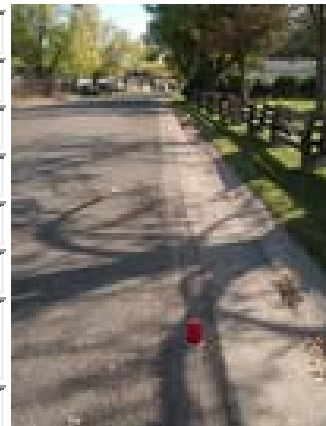
Barrier Type: No sidewalk

Code Ref: CBC 1127B.1 and ADA/ABA 206.2.1

As Built Meas: 1416 Quantity: LF

Description: No pedestrian route provided

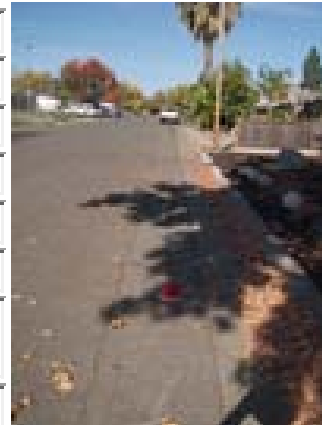
Barrier Type: No sidewalk

Code Ref: CBC 1127B.1 and ADA/ABA 206.2.1

As Built Meas: 1054 Quantity: LF

Description: No pedestrian route provided

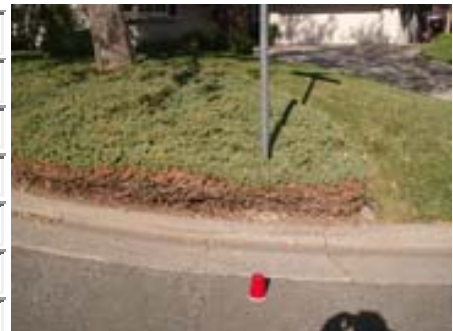
Barrier Type: Detectable Warnings - Truncated Domes

Code Ref: CBC 1127B.5.3

As Built Meas: 1 Quantity: EACH

Description: No truncated domes provided at transition into roadway

Bar. Severity: 2 Recommended Cost Estimate: \$1,400.00 Status:

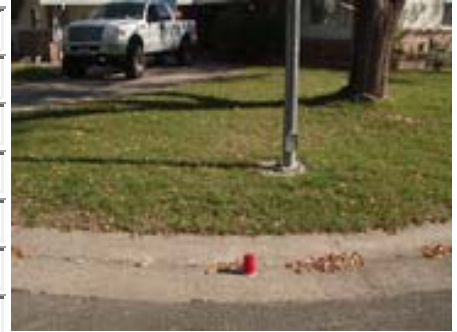
Barrier Type: Detectable Warnings - Truncated Domes

Code Ref: CBC 1127B.5.3

As Built Meas: 1 Quantity: EACH

Description: No truncated domes provided at transition into roadway

Bar. Severity: 2 Recommended Cost Estimate: \$1,400.00 Status:

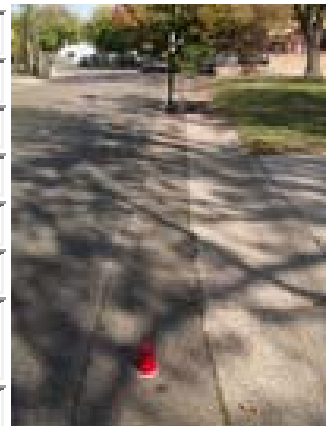
Barrier Type: No sidewalk

Code Ref: CBC 1127B.1 and ADA/ABA 206.2.1

As Built Meas: 334 Quantity: LF

Description: No pedestrian route provided

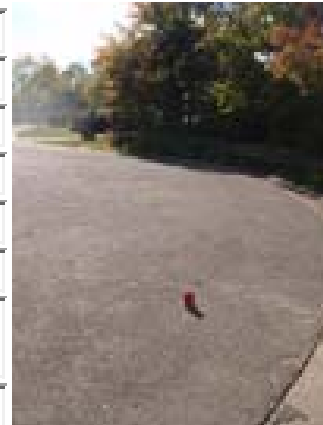
Barrier Type: No sidewalk

Code Ref: CBC 1127B.1 and ADA/ABA 206.2.1

As Built Meas: 327 Quantity: LF

Description: No pedestrian route provided

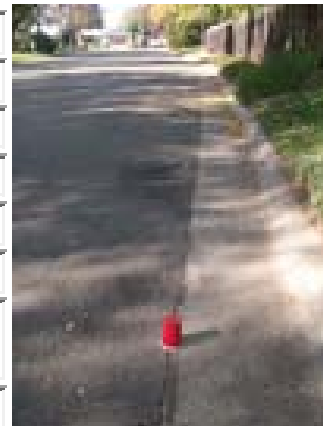
Barrier Type: No sidewalk

Code Ref: CBC 1127B.1 and ADA/ABA 206.2.1

As Built Meas: 278 Quantity: LF

Description: No pedestrian route provided

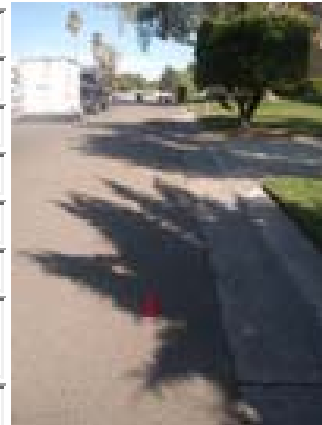
Barrier Type: No sidewalk

Code Ref: CBC 1127B.1 and ADA/ABA 206.2.1

As Built Meas: 868 Quantity: LF

Description: No pedestrian route provided

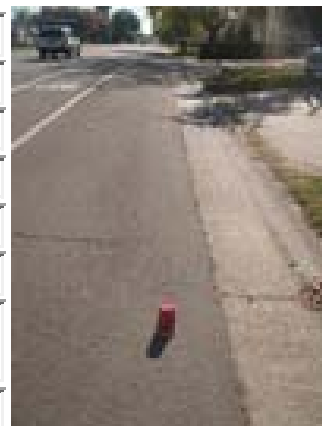
Barrier Type: Shoulder Cross Slope - Existing (4.1% to 4.9%)

Code Ref: CBC 1133B.7.1.3 and ADA/ABA 403.3

As Built Meas: 756 Quantity: LF

Description: Cross slope exceeds 2.0% (4.1% to 4.9%)

Bar. Severity: 2 Recommended Cost Estimate: \$94,500.00 Status:

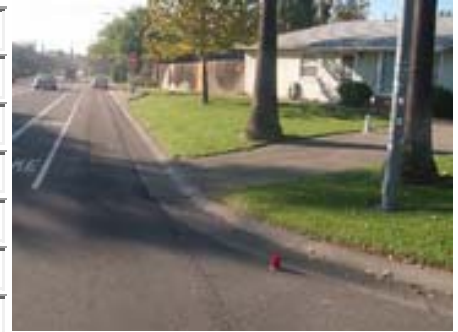
Barrier Type: Shoulder Cross Slope - Existing (3.1% to 4.0%)

Code Ref: CBC 1133B.7.1.3 and ADA/ABA 403.3

As Built Meas: 91 Quantity: LF

Description: Cross slope exceeds 2.0% (3.1% to 4.0%)

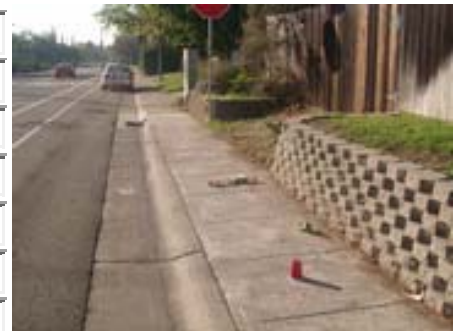
Barrier Type: Cross Slope - Existing (4.1% to 4.9%)

Code Ref: CBC 1133B.7.1.3 and ADA/ABA 403.3

As Built Meas: 90 Quantity: LF

Description: Cross slope exceeds 2.0% (4.1% to 4.9%)

Bar. Severity: 2 Recommended Cost Estimate: \$11,250.00 Status:

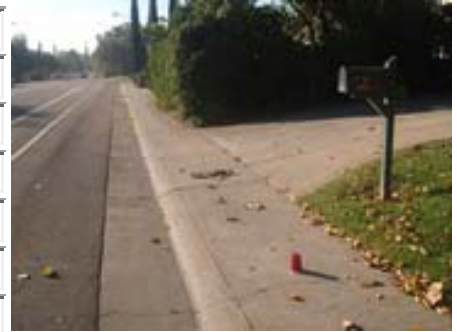
Field Date:	11/15/2010	Report Date:	11/15/2010	Barrier #:	2391
Location:	Van Maren Ln - West				
X Coordinate:	-121.30886				
Y Coordinate:	38.69989				
Barrier Area:	Sidewalks				
Barrier Type:	Cross Slope - Existing (5.0% or more)				
Code Ref:	CBC 1133B.7.1.3 and ADA/ABA 403.3

As Built Meas:	271	Quantity:	LF
Description:	Cross slope exceeds 2.0% (5.0% or more)		
As Built Desc:	5.1% cross slope		
Solution:	Demolish existing and construct new route		
Bar. Severity:	1 Necessary	Cost Estimate:	\$33,875.00
Implementation Priority:	1	Facility Function:	
Implementation Phase:		Implementation Date:	
Official Responsible:			
Notes:

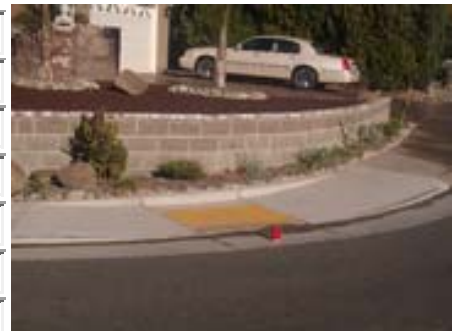
Field Date:	11/15/2010	Report Date:	11/15/2010	Barrier #:	2392
Location:	Van Maren Ln and Misty Creek Dr - Corner A				
X Coordinate:	-121.30881				
Y Coordinate:	38.69909				
Barrier Area:	Curb Ramps				
Barrier Type:	12" Grooves - New Construction				
Code Ref:	CBC 1127B.5.6

As Built Meas:	1	Quantity:	EACH
Description:	12" grooves at top of curb ramp are not level (4.1% to 4.9%)		
As Built Desc:	4.4% at 12" grooves - New Construction		
Solution:	Demolish existing and construct new curb ramp		
Bar. Severity:	1 Necessary	Cost Estimate:	\$2,500.00
Implementation Priority:	1	Facility Function:	
Implementation Phase:		Implementation Date:	
Official Responsible:			
Notes:	Two - way intersection. Corners A,D

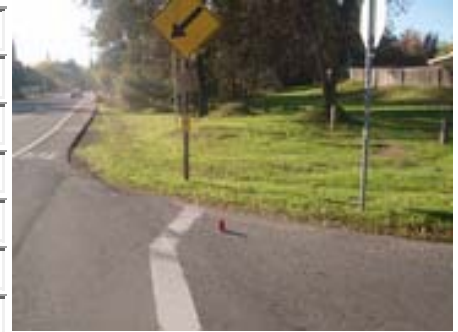
Barrier Type: Detectable Warnings - Truncated Domes

Code Ref: CBC 1127B.5.3

As Built Meas: 1 Quantity: EACH

Description: No truncated domes provided at transition into roadway

Bar. Severity: 2 Recommended Cost Estimate: \$1,400.00 Status:

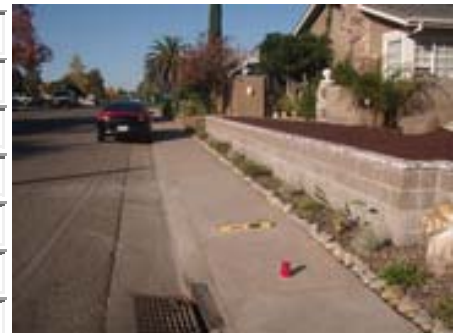
Barrier Type: Cross Slope - Existing (5.0% or more)

Code Ref: CBC 1133B.7.1.3 and ADA/ABA 403.3

As Built Meas: 175 Quantity: LF

Description: Cross slope exceeds 2.0% (5.0% or more)

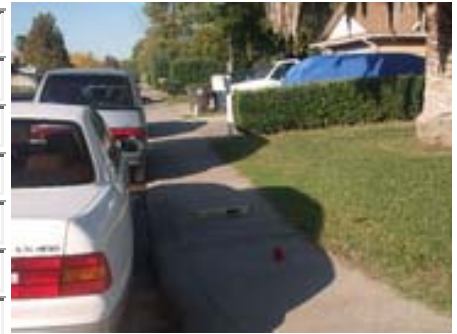
Barrier Type: Cross Slope - Existing (5.0% or more)

Code Ref: CBC 1133B.7.1.3 and ADA/ABA 403.3

As Built Meas: 609 Quantity: LF

Description: Cross slope exceeds 2.0% (5.0% or more)

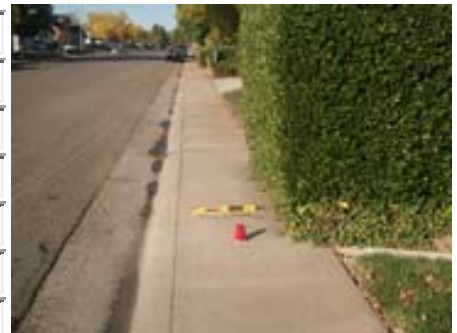
Barrier Type: Clear Width - Existing ($\leq 31"$ or less)

Code Ref: CBC 1133B.7.1

As Built Meas: 1 Quantity: LF

Description: Pedestrian route is not min. 48" wide ($\leq 31"$ or less)

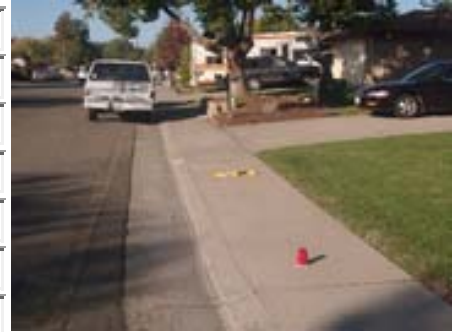
Barrier Type: Cross Slope - Existing (5.0% or more)

Code Ref: CBC 1133B.7.1.3 and ADA/ABA 403.3

As Built Meas: 976 Quantity: LF

Description: Cross slope exceeds 2.0% (5.0% or more)

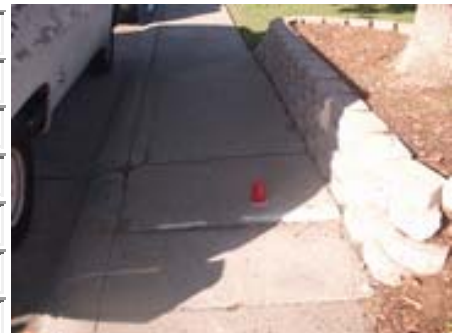
Barrier Type: Abrupt Change in Level - Tree Heaves

Code Ref: CBC 1133B.7.1 and ADA/ABA 303.3

As Built Meas: 4 Quantity: LF

Description: Change in level greater than 1/2"

Solution: Grind or repair sidewalk to remove trip hazard

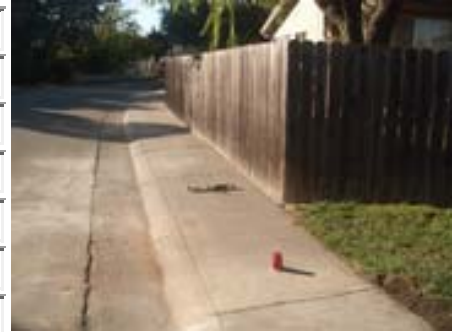
Barrier Type: Cross Slope - Existing (4.1% to 4.9%)

Code Ref: CBC 1133B.7.1.3 and ADA/ABA 403.3

As Built Meas: 142 Quantity: LF

Description: Cross slope exceeds 2.0% (4.1% to 4.9%)

Bar. Severity: 2 Recommended Cost Estimate: \$17,750.00 Status:

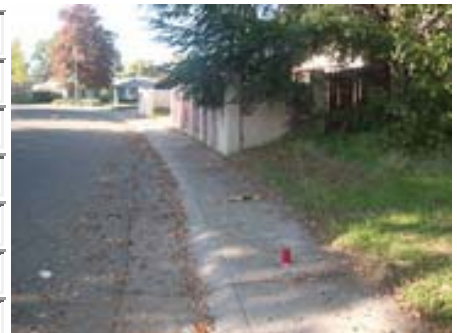
Barrier Type: Cross Slope - Existing (3.1% to 4.0%)

Code Ref: CBC 1133B.7.1.3 and ADA/ABA 403.3

As Built Meas: 80 Quantity: LF

Description: Cross slope exceeds 2.0% (3.1% to 4.0%)

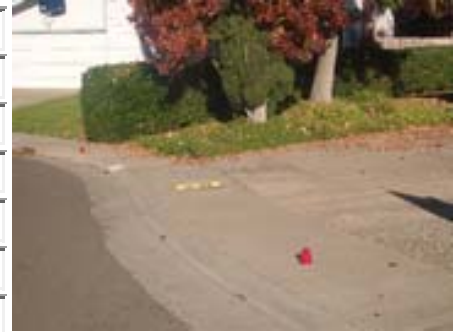
Barrier Type: Cross Slope - Existing (4.1% to 4.9%)

Code Ref: CBC 1133B.7.1.3 and ADA/ABA 403.3

As Built Meas: 53 Quantity: LF

Description: Cross slope exceeds 2.0% (4.1% to 4.9%)

Bar. Severity: 2 Recommended Cost Estimate: \$6,625.00 Status:

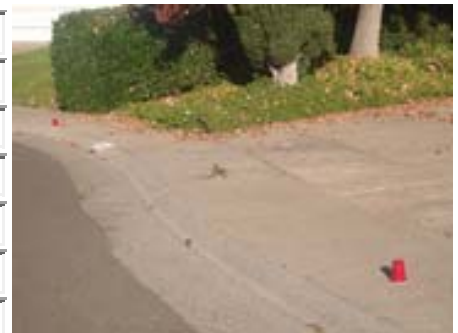
Barrier Type: Running Slope (Existing)

Code Ref: CBC 1133B.7.3 and ADA/ABA 403.3

As Built Meas: 53 Quantity: LF

Description: Running slope exceeds 5.0%

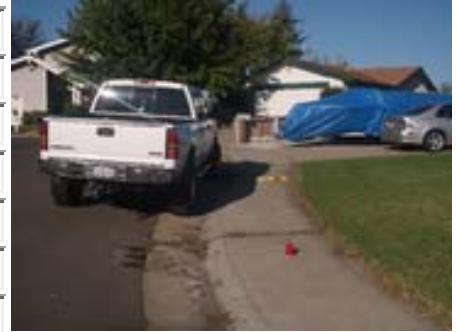
Barrier Type: Cross Slope - Existing (3.1% to 4.0%)

Code Ref: CBC 1133B.7.1.3 and ADA/ABA 403.3

As Built Meas: 107 Quantity: LF

Description: Cross slope exceeds 2.0% (3.1% to 4.0%)

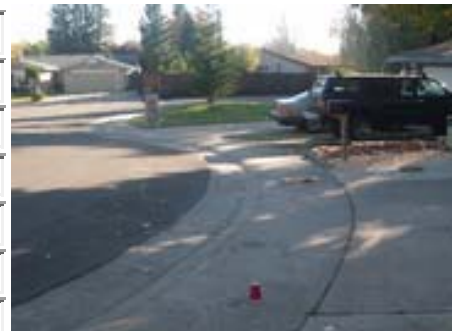
Barrier Type: Cross Slope - Existing (4.1% to 4.9%)

Code Ref: CBC 1133B.7.1.3 and ADA/ABA 403.3

As Built Meas: 86 Quantity: LF

Description: Cross slope exceeds 2.0% (4.1% to 4.9%)

Bar. Severity: 2 Recommended Cost Estimate: \$10,750.00 Status:

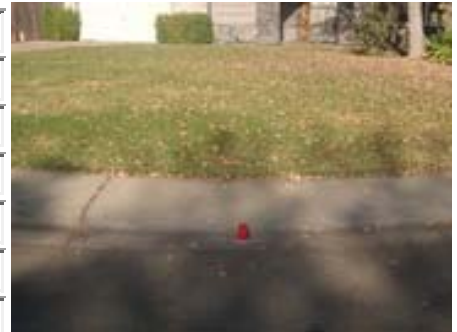
Barrier Type: No Curb Ramp - Depressed Existing Curb

Code Ref: CBC 1127B.5.1 and ADA/ABA 402.2

As Built Meas: 1 Quantity: EACH

Description: No compliant curb cut at corner (intersection)

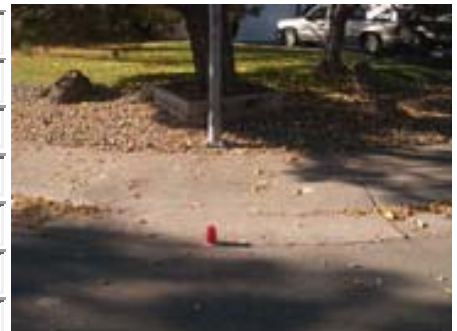
Barrier Type: No Curb Ramp - Depressed Existing Curb

Code Ref: CBC 1127B.5.1 and ADA/ABA 402.2

As Built Meas: 1 Quantity: EACH

Description: No compliant curb cut at corner (intersection)

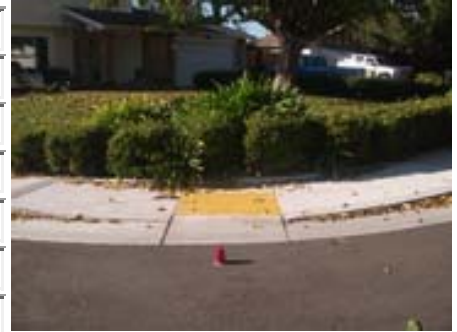
Barrier Type: 12" Grooves - New Construction

Code Ref: CBC 1127B.5.6

As Built Meas: 1 Quantity: EACH

Description: 12" grooves at top of curb ramp are not level (>5.0%)

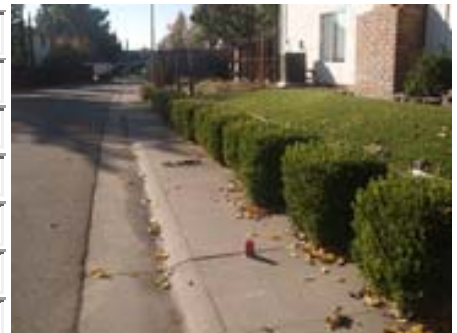
Barrier Type: Cross Slope - Existing (3.1% to 4.0%)

Code Ref: CBC 1133B.7.1.3 and ADA/ABA 403.3

As Built Meas: 80 Quantity: LF

Description: Cross slope exceeds 2.0% (3.1% to 4.0%)

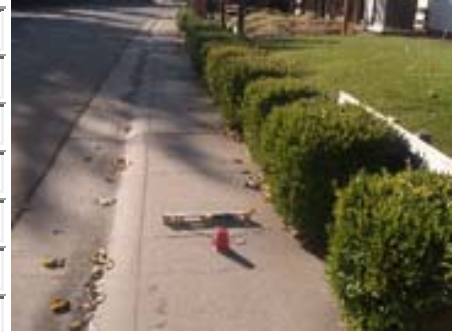
Barrier Type: Clear Width - Existing ($\leq 31"$ or less)

Description: Pedestrian route is not min. 48" wide ($\leq 31"$ or less)
