SZS CONSULTING GROUP

DRAFT ADA TRANSITION PLAN UPDATE
NEIGHBORHOOD AREA 3 CHANT
SEPTEMBER 20, 2011

CITY OF CITRUS HEIGHTS

Citrus Heights Area Three (CHANT)

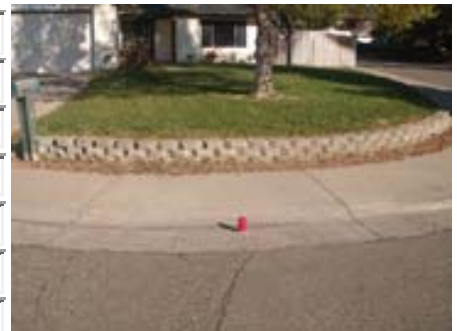
Barrier Type: No Curb Ramp - Depressed Existing Curb

Description: No compliant curb cut at corner (intersection)

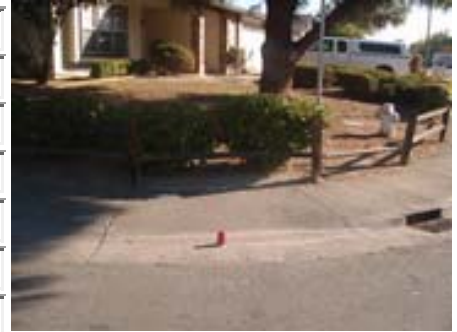
Barrier Type: No Curb Ramp - Depressed Existing Curb

Description: No compliant curb cut at corner (intersection)

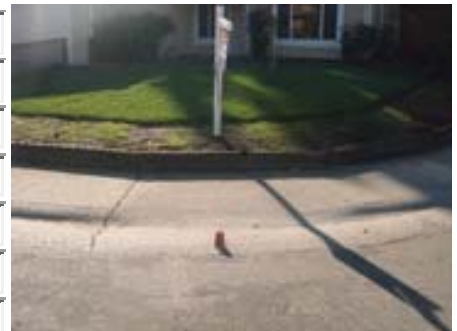
Barrier Type: No Curb Ramp - Depressed Existing Curb

Description: No compliant curb cut at corner (intersection)

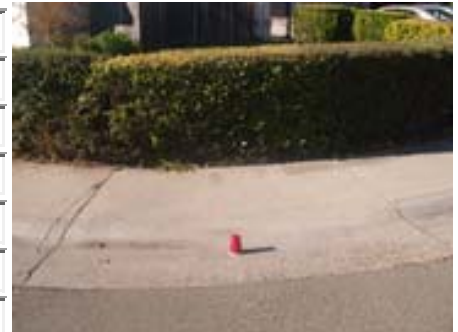
Barrier Type: No Curb Ramp - Depressed Existing Curb

Description: No compliant curb cut at corner (intersection)

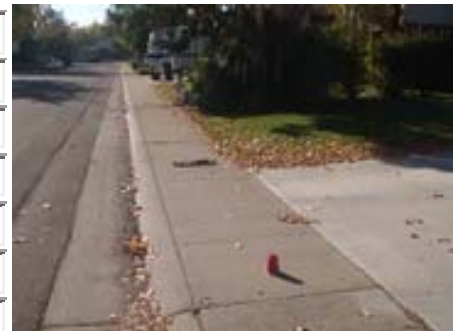
Barrier Type: Cross Slope - Existing (4.1% to 4.9%)

Description: Cross slope exceeds 2.0% (4.1% to 4.9%)

Bar. Severity: 2 Recommended Cost Estimate: \$14,375.00 Status:

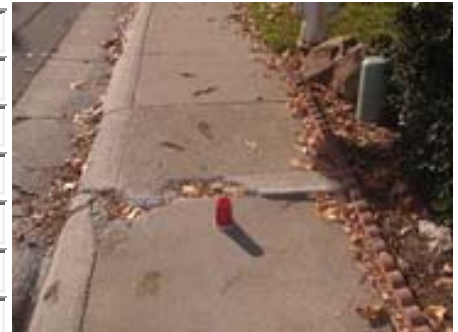
Barrier Type: Abrupt Change in Level - > 1/2"

Description: Change in level greater than 1/2"

Solution: Grind or repair sidewalk to remove trip hazard

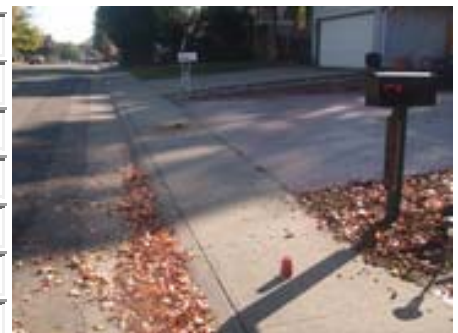
Barrier Type: Cross Slope - Existing (3.1% to 4.0%)

Description: Cross slope exceeds 2.0% (3.1% to 4.0%)

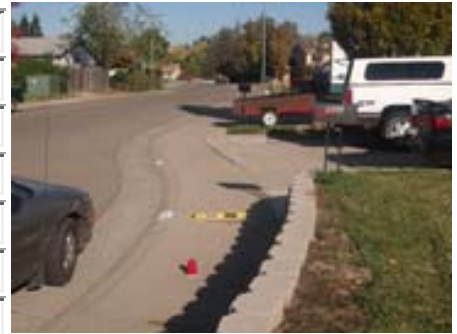
Field Date:	11/15/2010	Report Date:	11/15/2010	Barrier #:	2413
Location:	Sunburst Wy - East				
X Coordinate:	-121.31397				
Y Coordinate:	38.693				
Barrier Area:	Sidewalks				
Barrier Type:	Cross Slope - Existing (3.1% to 4.0%)				
Code Ref:	CBC 1133B.7.1.3 and ADA/ABA 403.3

As Built Meas:	429	Quantity:	LF
Description:	Cross slope exceeds 2.0% (3.1% to 4.0%)		
As Built Desc:	3.6% cross slope		
Solution:	Demolish existing and construct new route		
Bar. Severity:	3 Hindrance	Cost Estimate:	\$53,625.00
Implementation Priority:	4	Facility Function:	
Implementation Phase:		Implementation Date:	
Official Responsible:

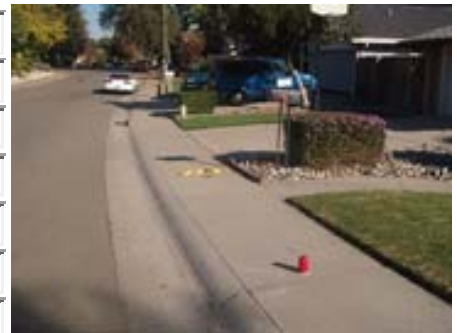
Field Date:	11/15/2010	Report Date:	11/15/2010	Barrier #:	2414
Location:	Sunburst Wy - East				
X Coordinate:	-121.3142				
Y Coordinate:	38.69438				
Barrier Area:	Sidewalks				
Barrier Type:	Cross Slope - Existing (5.0% or more)				
Code Ref:	CBC 1133B.7.1.3 and ADA/ABA 403.3

As Built Meas:	435	Quantity:	LF
Description:	Cross slope exceeds 2.0% (5.0% or more)		
As Built Desc:	6.3% cross slope		
Solution:	Demolish existing and construct new route		
Bar. Severity:	1 Necessary	Cost Estimate:	\$54,375.00
Implementation Priority:	4	Facility Function:	
Implementation Phase:		Implementation Date:	
Official Responsible:

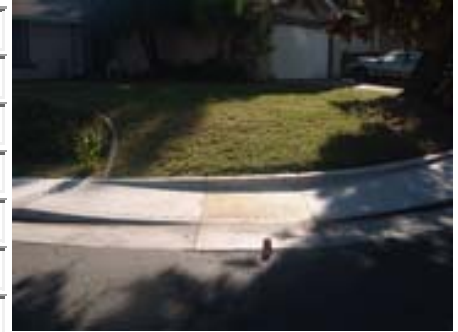
Barrier Type: 12" Grooves - New Construction

Description: 12" grooves at top of curb ramp are not level (>5.0%)

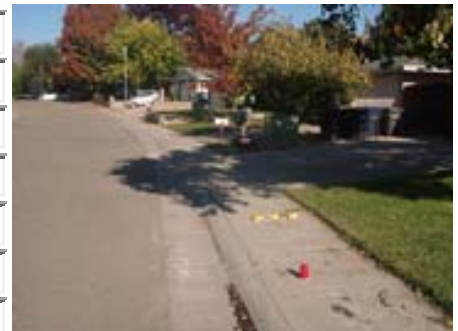
Barrier Type: Cross Slope - Existing (5.0% or more)

Description: Cross slope exceeds 2.0% (5.0% or more)

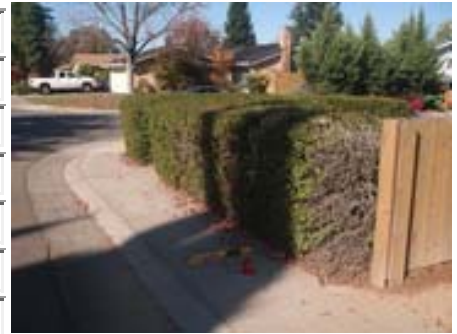
Barrier Type: Clear Width - Existing ($\leq 31"$ or less)

Description: Pedestrian route is not min. 48" wide ($\leq 31"$ or less)

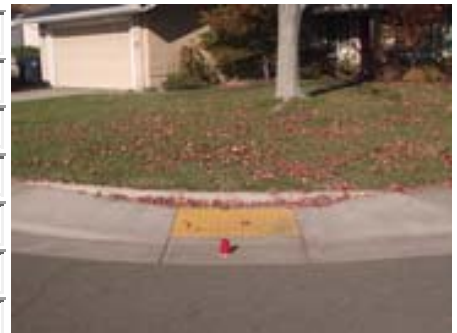
Barrier Type: 12" Grooves - New Construction

Description: 12" grooves at top of curb ramp are not level (3.1% to 4.0%)

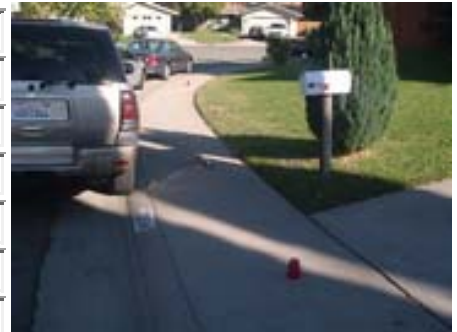
Barrier Type: Running Slope (Existing)

Description: Running slope exceeds 5.0%

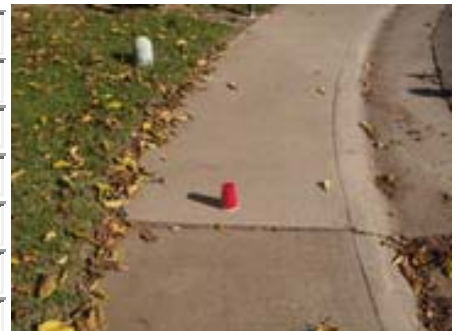
Barrier Type: Abrupt Change in Level - > 1/2"

Description: Change in level greater than 1/2"

Solution: Grind or repair sidewalk to remove trip hazard

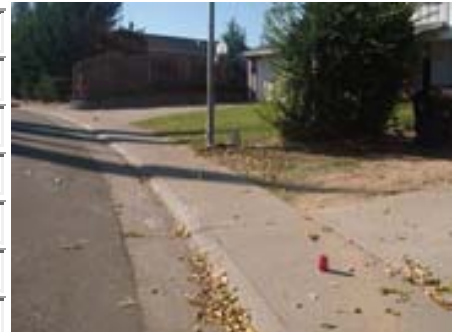
Barrier Type: Running Slope (Existing)

Description: Running slope exceeds 5.0%

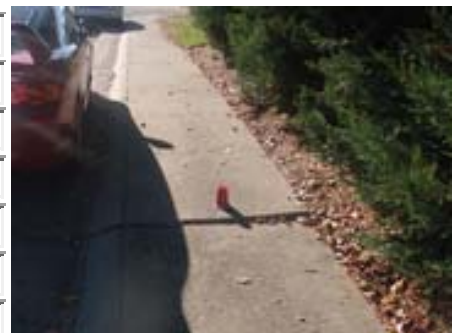
Barrier Type: Abrupt Change in Level - > 1/2"

Description: Change in level greater than 1/2"

Solution: Grind or repair sidewalk to remove trip hazard

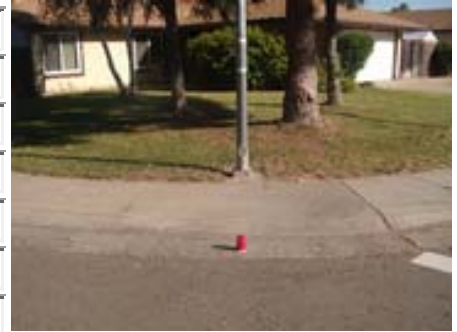
Field Date:	11/15/2010	Report Date:	11/15/2010	Barrier #:	2422
Location:	Sunmist Wy and Sunburst Wy - Corner B				
X Coordinate:	-121.31713				
Y Coordinate:	38.69718				
Barrier Area:	Curb Ramps				
Barrier Type:	No Curb Ramp - Depressed Existing Curb				
Code Ref:	CBC 1127B.5.1 and ADA/ABA 402.2

As Built Meas:	1	Quantity:	EACH	
Description:	No compliant curb cut at corner (intersection)			
As Built Desc:	7.9% running slope at depressed area			
Solution:	Demolish existing and construct curb cut			
Bar. Severity:	1 Necessary	Cost Estimate:	\$2,500.00	Status:
Implementation Priority:	4	Facility Function:		
Implementation Phase:		Implementation Date:		
Official Responsible:				
Notes:	Two - way intersection. Corners B,C

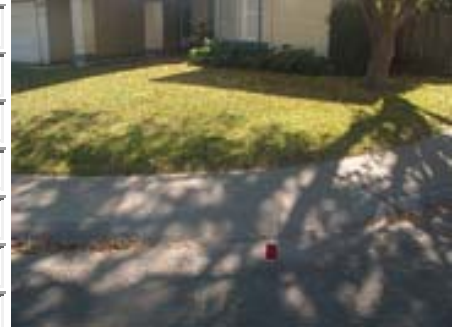
Field Date:	11/15/2010	Report Date:	11/15/2010	Barrier #:	2423
Location:	Sunmist Wy and Sunburst Wy - Corner C				
X Coordinate:	-121.31712				
Y Coordinate:	38.69712				
Barrier Area:	Curb Ramps				
Barrier Type:	No Curb Ramp - Depressed Existing Curb				
Code Ref:	CBC 1127B.5.1 and ADA/ABA 402.2

As Built Meas:	1	Quantity:	EACH	
Description:	No compliant curb cut at corner (intersection)			
As Built Desc:	8.4% running slope at depressed area			
Solution:	Demolish existing and construct curb cut			
Bar. Severity:	1 Necessary	Cost Estimate:	\$2,500.00	Status:
Implementation Priority:	4	Facility Function:		
Implementation Phase:		Implementation Date:		
Official Responsible:				
Notes:	Two - way intersection. Corners B,C

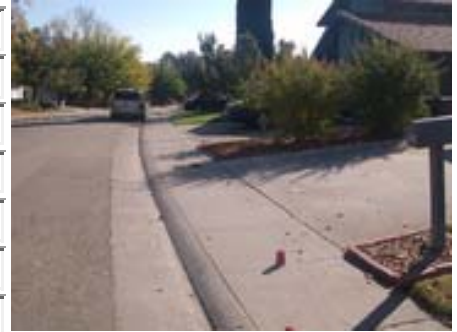
Field Date:	11/15/2010	Report Date:	11/15/2010	Barrier #:	2424
Location:	Sunburst Wy - West				
X Coordinate:	-121.31698				
Y Coordinate:	38.69713				
Barrier Area:	Sidewalks				
Barrier Type:	Cross Slope - Existing (5.0% or more)				
Code Ref:	CBC 1133B.7.1.3 and ADA/ABA 403.3

As Built Meas:	923	Quantity:	LF
Description:	Cross slope exceeds 2.0% (5.0% or more)		
As Built Desc:	7.4% cross slope		
Solution:	Demolish existing and construct new route		
Bar. Severity:	1 Necessary	Cost Estimate:	\$115,375.00
Implementation Priority:	4	Facility Function:	
Implementation Phase:		Implementation Date:	
Official Responsible:			
Notes:

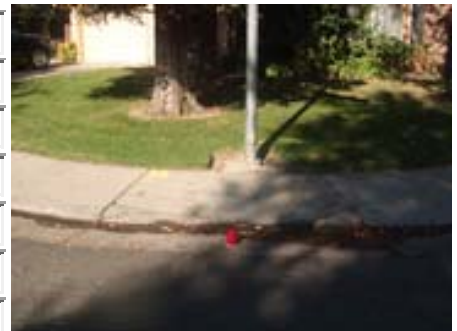
Field Date:	11/15/2010	Report Date:	11/15/2010	Barrier #:	2425
Location:	Sunburst Wy and Twin Wood Wy - Corner A				
X Coordinate:	-121.31412				
Y Coordinate:	38.69494				
Barrier Area:	Curb Ramps				
Barrier Type:	No Curb Ramp - Depressed Existing Curb				
Code Ref:	CBC 1127B.5.1 and ADA/ABA 402.2

As Built Meas:	1	Quantity:	EACH
Description:	No compliant curb cut at corner (intersection)		
As Built Desc:	16.4% running slope at depressed area		
Solution:	Demolish existing and construct curb cut		
Bar. Severity:	1 Necessary	Cost Estimate:	\$2,500.00
Implementation Priority:	4	Facility Function:	
Implementation Phase:		Implementation Date:	
Official Responsible:			
Notes:	Two - way intersection. Corners A,D

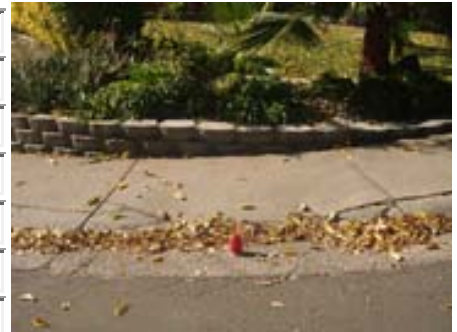
Barrier Type: No Curb Ramp - Depressed Existing Curb

Description: No compliant curb cut at corner (intersection)

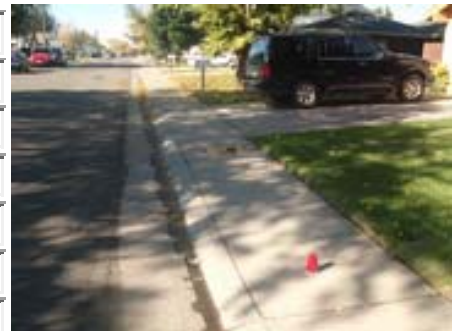
Barrier Type: Cross Slope - Existing (5.0% or more)

Description: Cross slope exceeds 2.0% (5.0% or more)

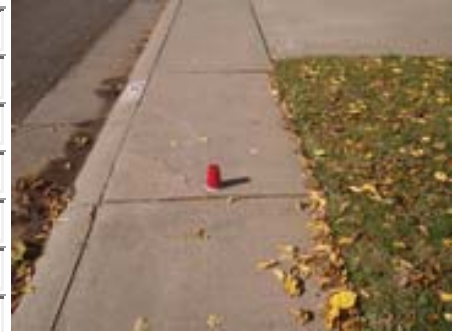
Barrier Type: Abrupt Change in Level - > 1/2"

Description: Change in level greater than 1/2"

Solution: Grind or repair sidewalk to remove trip hazard

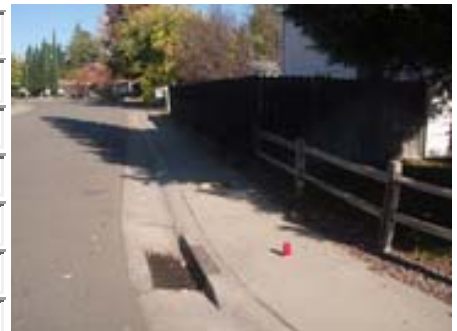
Barrier Type: Cross Slope - Existing (5.0% or more)

Description: Cross slope exceeds 2.0% (5.0% or more)

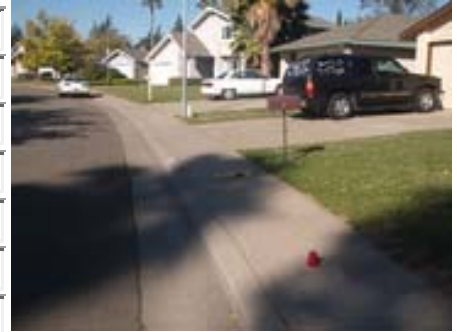
Barrier Type: Cross Slope - Existing (5.0% or more)

Description: Cross slope exceeds 2.0% (5.0% or more)

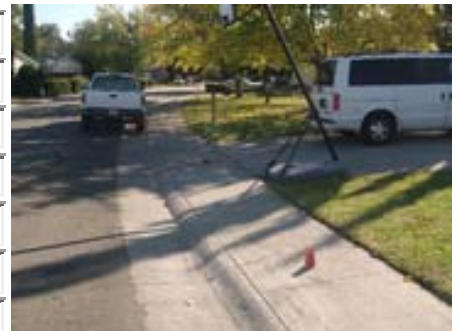
Barrier Type: Cross Slope - Existing (5.0% or more)

Description: Cross slope exceeds 2.0% (5.0% or more)

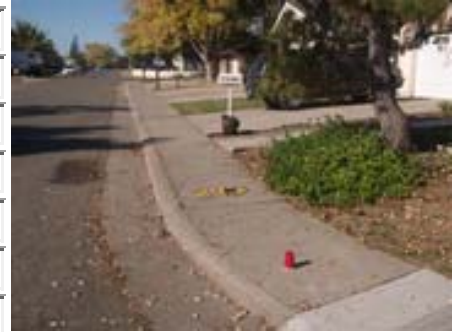
Field Date:	11/15/2010	Report Date:	11/15/2010	Barrier #:	2431
Location:	Twin Wood Wy - North				
X Coordinate:	-121.31509				
Y Coordinate:	38.69504				
Barrier Area:	Sidewalks				
Barrier Type:	Cross Slope - Existing (3.1% to 4.0%)				
Code Ref:	CBC 1133B.7.1.3 and ADA/ABA 403.3

As Built Meas:	183	Quantity:	LF
Description:	Cross slope exceeds 2.0% (3.1% to 4.0%)		
As Built Desc:	3.8% cross slope		
Solution:	Demolish existing and construct new route		
Bar. Severity:	3 Hindrance	Cost Estimate:	\$22,875.00
Implementation Priority:	4	Facility Function:	
Implementation Phase:		Implementation Date:	
Official Responsible:			
Notes:

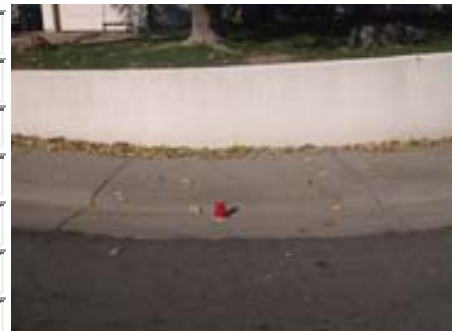
As Built Meas:	1	Quantity:	EACH
Description:	No compliant curb cut at corner (intersection)		
As Built Desc:	14.1% running slope at depressed area		
Solution:	Demolish existing and construct curb cut		
Bar. Severity:	1 Necessary	Cost Estimate:	\$2,500.00
Implementation Priority:	4	Facility Function:	
Implementation Phase:		Implementation Date:	
Official Responsible:			
Notes:	Two - way intersection. Corners A,B

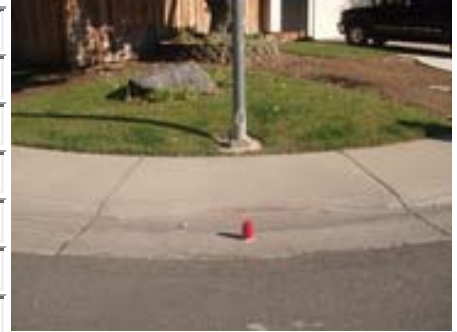
Barrier Type: No Curb Ramp - Depressed Existing Curb

Description: No compliant curb cut at corner (intersection)

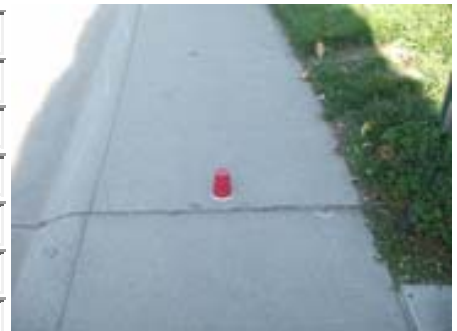
Barrier Type: Abrupt Change in Level - > 1/2"

Description: Change in level greater than 1/2"

Solution: Grind or repair sidewalk to remove trip hazard

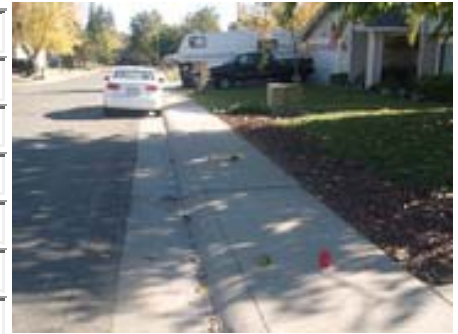
Barrier Type: Cross Slope - Existing (5.0% or more)

Description: Cross slope exceeds 2.0% (5.0% or more)

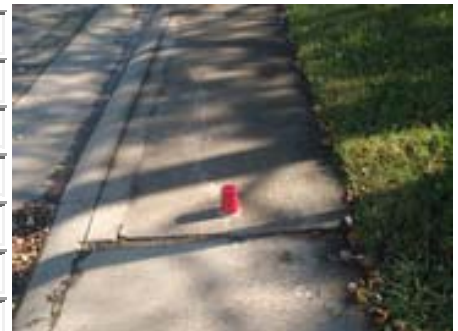
Barrier Type: Abrupt Change in Level - > 1/2"

Description: Change in level greater than 1/2"

Solution: Grind or repair sidewalk to remove trip hazard

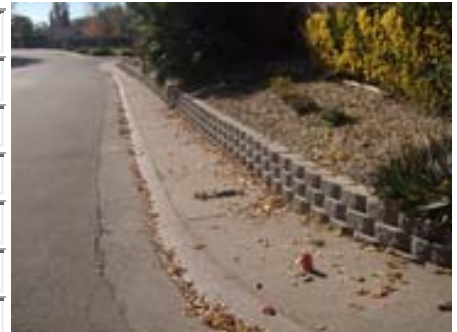
Barrier Type: Cross Slope - Existing (5.0% or more)

Description: Cross slope exceeds 2.0% (5.0% or more)

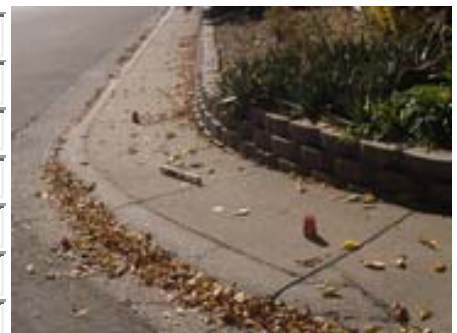
Barrier Type: Running Slope (Existing)

Description: Running slope exceeds 5.0%

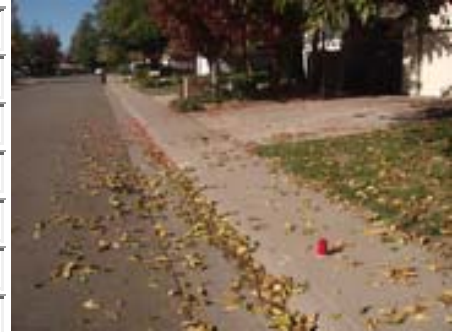
Field Date:	11/15/2010	Report Date:	11/15/2010	Barrier #:	2437
Location:	Silkwood Wy - North				
X Coordinate:	-121.31489				
Y Coordinate:	38.69437				
Barrier Area:	Sidewalks				
Barrier Type:	Cross Slope - Existing (3.1% to 4.0%)				
Code Ref:	CBC 1133B.7.1.3 and ADA/ABA 403.3

As Built Meas:	214	Quantity:	LF
Description:	Cross slope exceeds 2.0% (3.1% to 4.0%)		
As Built Desc:	3.9% cross slope		
Solution:	Demolish existing and construct new route		
Bar. Severity:	3 Hindrance	Cost Estimate:	\$26,750.00
Implementation Priority:	4	Facility Function:	
Implementation Phase:		Implementation Date:	
Official Responsible:			
Notes:

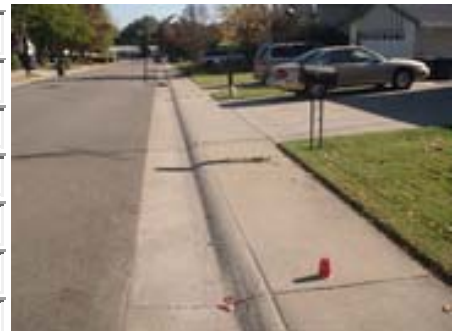
Field Date:	11/15/2010	Report Date:	11/15/2010	Barrier #:	2438
Location:	Silkwood Wy - South				
X Coordinate:	-121.3159				
Y Coordinate:	38.69435				
Barrier Area:	Sidewalks				
Barrier Type:	Cross Slope - Existing (3.1% to 4.0%)				
Code Ref:	CBC 1133B.7.1.3 and ADA/ABA 403.3

As Built Meas:	287	Quantity:	LF
Description:	Cross slope exceeds 2.0% (3.1% to 4.0%)		
As Built Desc:	3.1% cross slope		
Solution:	Demolish existing and construct new route		
Bar. Severity:	3 Hindrance	Cost Estimate:	\$35,875.00
Implementation Priority:	4	Facility Function:	
Implementation Phase:		Implementation Date:	
Official Responsible:			
Notes:

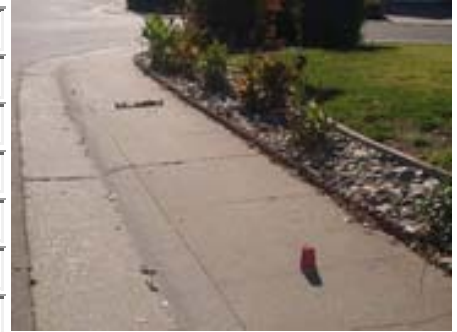
Barrier Type: Cross Slope - Existing (3.1% to 4.0%)

Description: Cross slope exceeds 2.0% (3.1% to 4.0%)

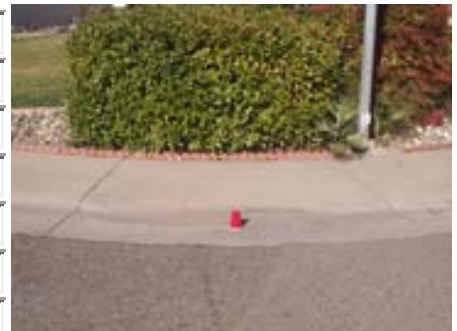
Barrier Type: No Curb Ramp - Depressed Existing Curb

Description: No compliant curb cut at corner (intersection)

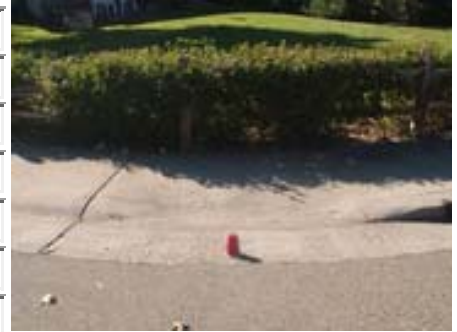
Barrier Type: No Curb Ramp - Depressed Existing Curb

Description: No compliant curb cut at corner (intersection)

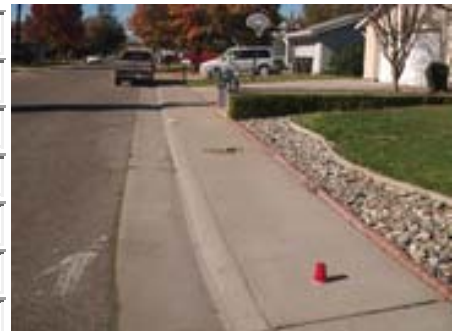
Barrier Type: Cross Slope - Existing (3.1% to 4.0%)

Description: Cross slope exceeds 2.0% (3.1% to 4.0%)

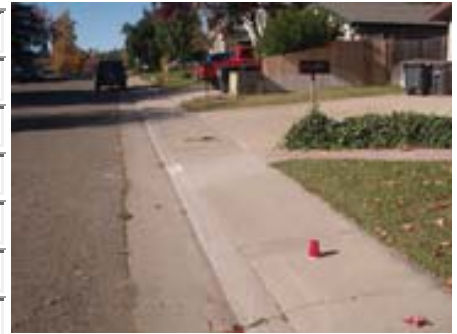
Field Date:	11/15/2010	Report Date:	11/15/2010	Barrier #:	2443
Location:	Shady Springs Wy - North				
X Coordinate:	-121.31566				
Y Coordinate:	38.69371				
Barrier Area:	Sidewalks				
Barrier Type:	Cross Slope - Existing (3.1% to 4.0%)				
Code Ref:	CBC 1133B.7.1.3 and ADA/ABA 403.3

As Built Meas:	137	Quantity:	LF	
Description:	Cross slope exceeds 2.0% (3.1% to 4.0%)			
As Built Desc:	3.9% cross slope			
Solution:	Demolish existing and construct new route			
Bar. Severity:	3 Hindrance	Cost Estimate:	\$17,125.00	Status:
Implementation Priority:	4	Facility Function:		
Implementation Phase:		Implementation Date:		
Official Responsible:

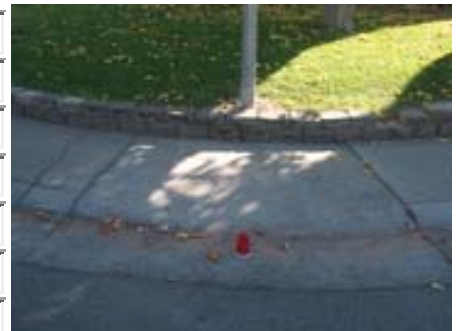
As Built Meas:	1	Quantity:	EACH	
Description:	No compliant curb cut at corner (intersection)			
As Built Desc:	9.0% running slope at depressed area			
Solution:	Demolish existing and construct curb cut			
Bar. Severity:	1 Necessary	Cost Estimate:	\$2,500.00	Status:
Implementation Priority:	4	Facility Function:		
Implementation Phase:		Implementation Date:		
Official Responsible:

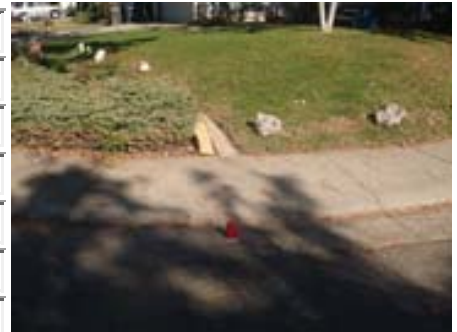
Barrier Type: No Curb Ramp - Depressed Existing Curb

Description: No compliant curb cut at corner (intersection)

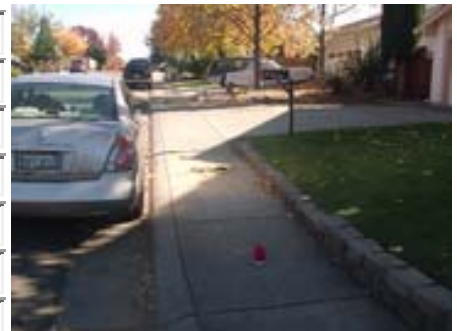
Barrier Type: Cross Slope - Existing (4.1% to 4.9%)

Description: Cross slope exceeds 2.0% (4.1% to 4.9%)

Bar. Severity: 2 Recommended Cost Estimate: \$90,000.00 Status:

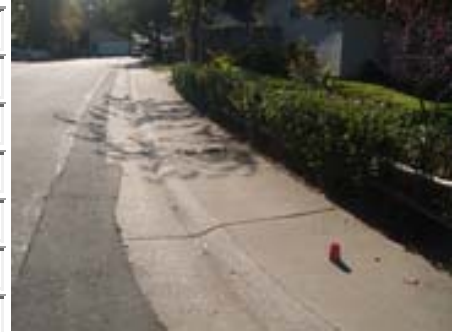
Barrier Type: Cross Slope - Existing (3.1% to 4.0%)

Description: Cross slope exceeds 2.0% (3.1% to 4.0%)

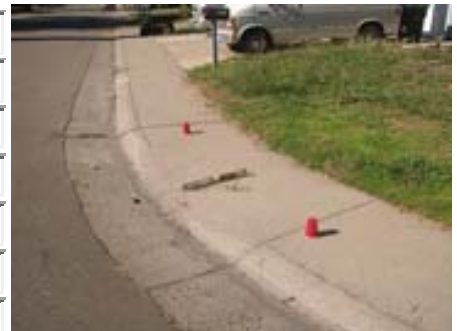
Barrier Type: Elbow in Sidewalk - Cross Slope (5.0% or more)

Description: Cross slope at elbow exceeds 2.0% (5.0% or more)

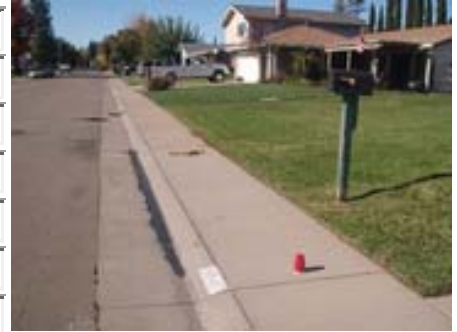
Barrier Type: Cross Slope - Existing (4.1% to 4.9%)

Description: Cross slope exceeds 2.0% (4.1% to 4.9%)

Bar. Severity: 2 Recommended Cost Estimate: \$86,875.00 Status:

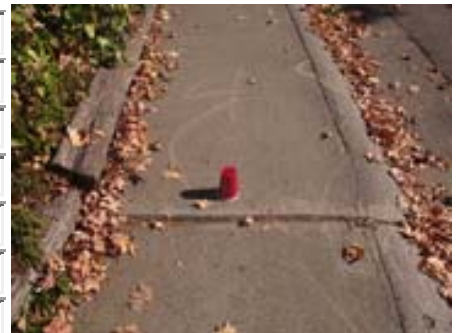
Barrier Type: Abrupt Change in Level - > 1/2"

Description: Change in level greater than 1/2"

Solution: Grind or repair sidewalk to remove trip hazard

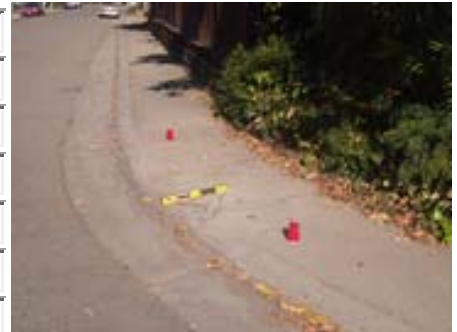
Barrier Type: Elbow in Sidewalk - Cross Slope (5.0% or more)

Description: Cross slope at elbow exceeds 2.0% (5.0% or more)

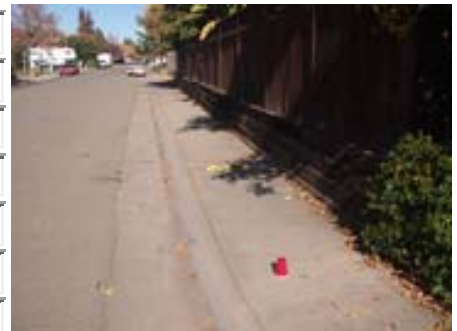
Barrier Type: Cross Slope - Existing (4.1% to 4.9%)

Description: Cross slope exceeds 2.0% (4.1% to 4.9%)

Bar. Severity: 2 Recommended Cost Estimate: \$22,000.00 Status:

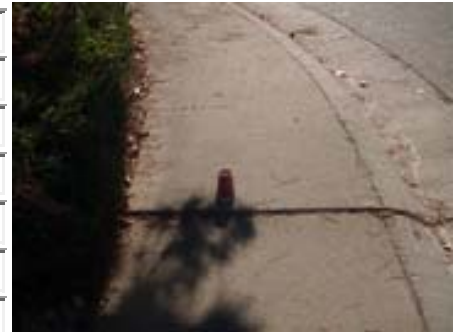
Barrier Type: Abrupt Change in Level - > 1/2"

Description: Change in level greater than 1/2"

Solution: Grind or repair sidewalk to remove trip hazard

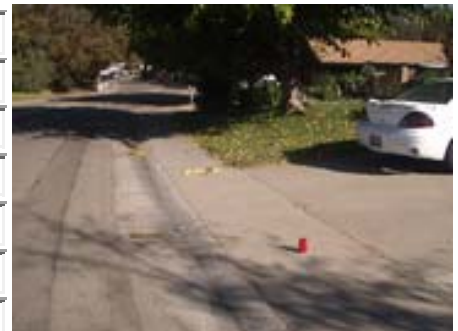
Barrier Type: Cross Slope - Existing (4.1% to 4.9%)

Description: Cross slope exceeds 2.0% (4.1% to 4.9%)

Bar. Severity: 2 Recommended Cost Estimate: \$7,000.00 Status:

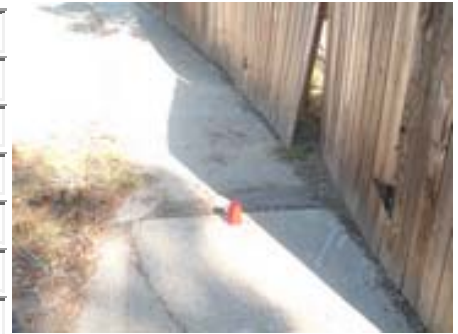
Barrier Type: Abrupt Change in Level - > 1/2"

Description: Change in level greater than 1/2"

Solution: Grind or repair sidewalk to remove trip hazard

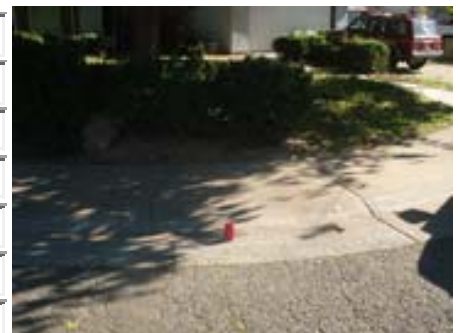
Barrier Type: No Curb Ramp - Depressed Existing Curb

Description: No compliant curb cut at corner (intersection)

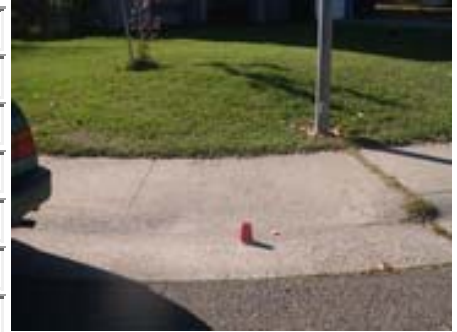
Barrier Type: No Curb Ramp - Depressed Existing Curb

Description: No compliant curb cut at corner (intersection)

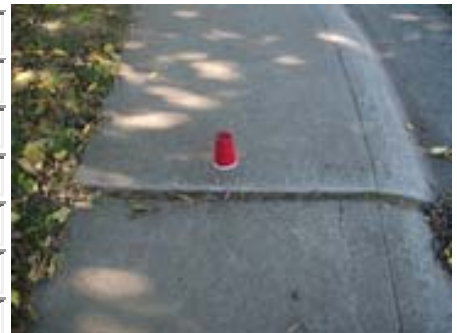
Barrier Type: Abrupt Change in Level - > 1/2"

Description: Change in level greater than 1/2"

Solution: Grind or repair sidewalk to remove trip hazard

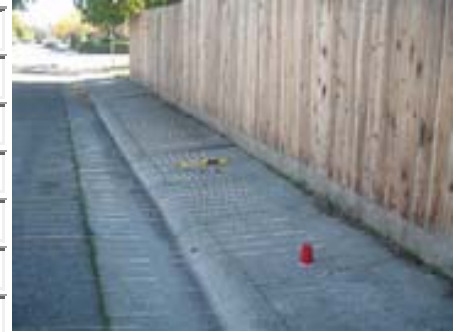
Barrier Type: Cross Slope - Existing (5.0% or more)

Description: Cross slope exceeds 2.0% (5.0% or more)

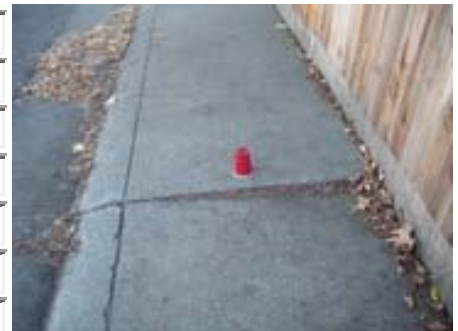
Barrier Type: Abrupt Change in Level - > 1/2"

Description: Change in level greater than 1/2"

Solution: Grind or repair sidewalk to remove trip hazard

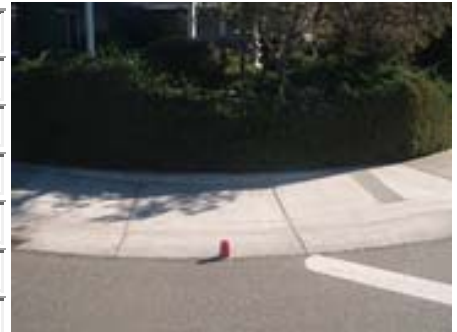
Barrier Type: Detectable Warnings - Truncated Domes

Description: No truncated domes provided at curb ramp

Bar. Severity: 2 Recommended Cost Estimate: \$1,400.00 Status:

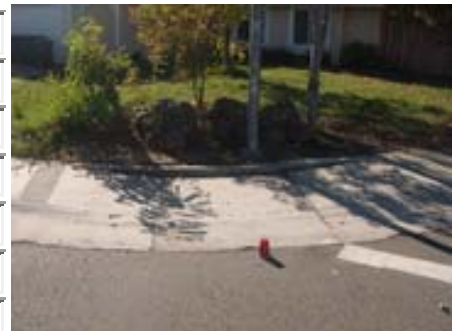
Barrier Type: Abrupt Change in Level - > 1/2"

Description: Change in level greater than 1/2" in curb ramp

Solution: Grind or repair to remove trip hazard

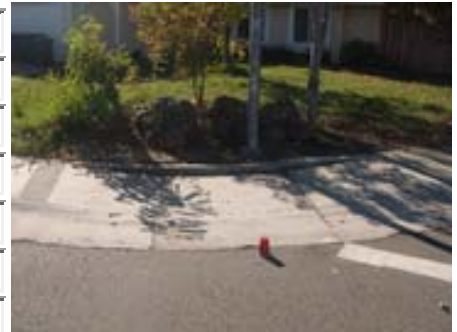
Barrier Type: Detectable Warnings - Truncated Domes

Description: No truncated domes provided at curb ramp

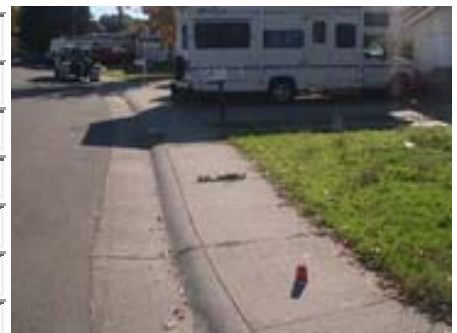
Barrier Type: Cross Slope - Existing (5.0% or more)

Description: Cross slope exceeds 2.0% (5.0% or more)

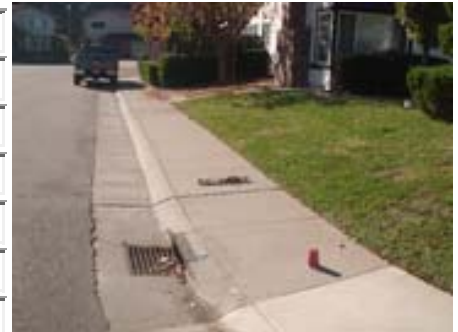
Field Date:	11/15/2010	Report Date:	11/15/2010	Barrier #:	2462
Location:	Hillspire Ct - North				
X Coordinate:	-121.31325				
Y Coordinate:	38.69764				
Barrier Area:	Sidewalks				
Barrier Type:	Cross Slope - Existing (5.0% or more)				
Code Ref:	CBC 1133B.7.1.3 and ADA/ABA 403.3

As Built Meas:	221	Quantity:	LF
Description:	Cross slope exceeds 2.0% (5.0% or more)		
As Built Desc:	6.0% cross slope		
Solution:	Demolish existing and construct new route		
Bar. Severity:	1 Necessary	Cost Estimate:	\$27,625.00
Implementation Priority:	4	Facility Function:	
Implementation Phase:		Implementation Date:	
Official Responsible:			
Notes:

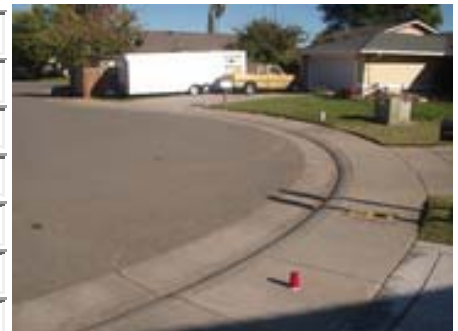
Field Date:	11/15/2010	Report Date:	11/15/2010	Barrier #:	2463
Location:	Hillspire Ct - South				
X Coordinate:	-121.31371				
Y Coordinate:	38.6973				
Barrier Area:	Sidewalks				
Barrier Type:	Cross Slope - Existing (5.0% or more)				
Code Ref:	CBC 1133B.7.1.3 and ADA/ABA 403.3

As Built Meas:	197	Quantity:	LF
Description:	Cross slope exceeds 2.0% (5.0% or more)		
As Built Desc:	6.9% cross slope		
Solution:	Demolish existing and construct new route		
Bar. Severity:	1 Necessary	Cost Estimate:	\$24,625.00
Implementation Priority:	4	Facility Function:	
Implementation Phase:		Implementation Date:	
Official Responsible:			
Notes:

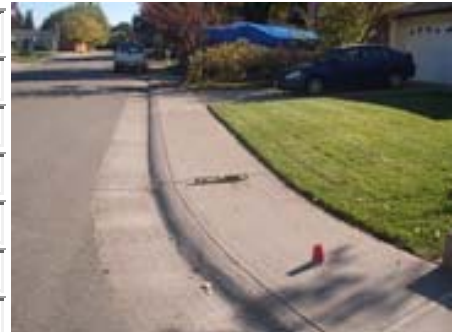
Field Date:	11/15/2010	Report Date:	11/15/2010	Barrier #:	2464
Location:	Starflower Dr - West				
X Coordinate:	-121.31317				
Y Coordinate:	38.69756				
Barrier Area:	Sidewalks				
Barrier Type:	Cross Slope - Existing (5.0% or more)				
Code Ref:	CBC 1133B.7.1.3 and ADA/ABA 403.3

As Built Meas:	177	Quantity:	LF
Description:	Cross slope exceeds 2.0% (5.0% or more)		
As Built Desc:	5.5% cross slope		
Solution:	Demolish existing and construct new route		
Bar. Severity:	1 Necessary	Cost Estimate:	\$22,125.00
Implementation Priority:	2	Facility Function:	
Implementation Phase:		Implementation Date:	
Official Responsible:			
Notes:

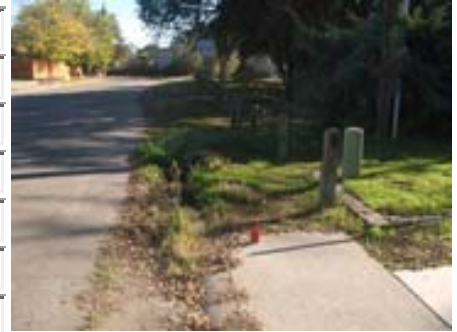
Barrier Type: No Sidewalk - Transition to Shoulder

Description: Sidewalk ends and no ramp to pedestrian shoulder is provided

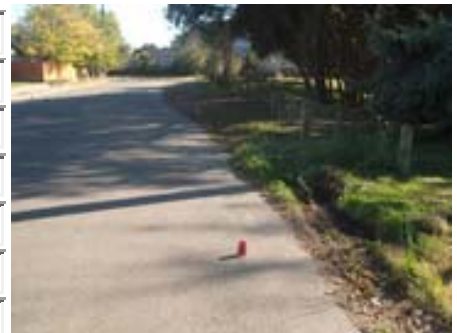
Barrier Type: Shoulder Cross Slope - Existing (2.1% to 3.0%)

Description: Cross slope exceeds 2.0% (2.1% to 3.0%)

Solution: Low severity barrier - no remediation recommended

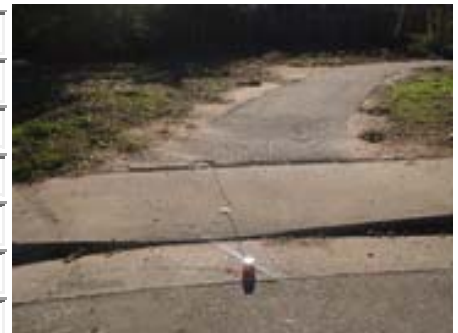
Barrier Type: Lip - Bottom of Ramp at Flow Line

Description: Transition at ramp bottom (flow line) is not flush and free of any lip

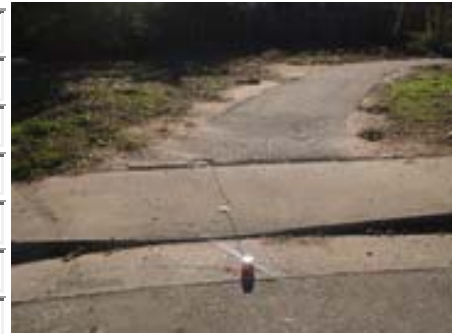
Barrier Type: Detectable Warnings - Truncated Domes

Description: No truncated domes provided at curb ramp

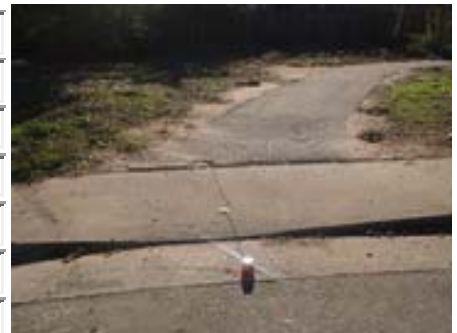
Barrier Type: Parallel Ramp Landing - Existing (>5.0% or more)

Description: Curb ramp landing or pan not level (>5.0% or more)

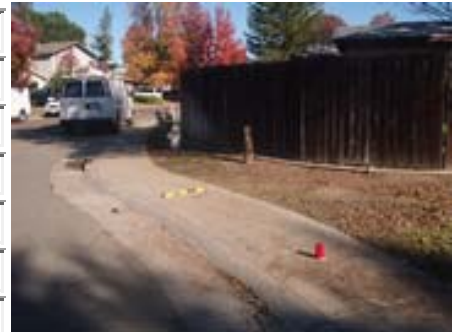
Barrier Type: Cross Slope - Existing (4.1% to 4.9%)

Description: Cross slope exceeds 2.0% (4.1% to 4.9%)

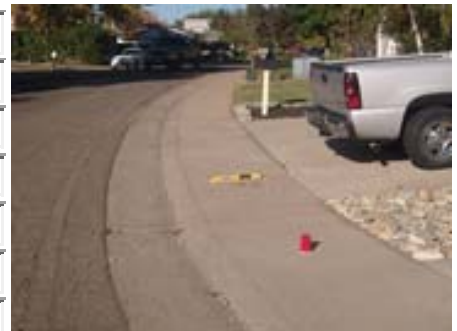
Barrier Type: Cross Slope - Existing (4.1% to 4.9%)

Description: Cross slope exceeds 2.0% (4.1% to 4.9%)

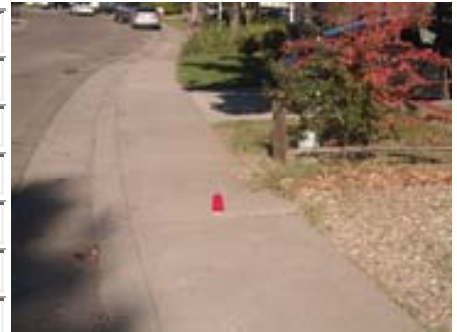
Barrier Type: Abrupt Change in Level - > 1/2"

Description: Change in level greater than 1/2"

Solution: Grind or repair sidewalk to remove trip hazard

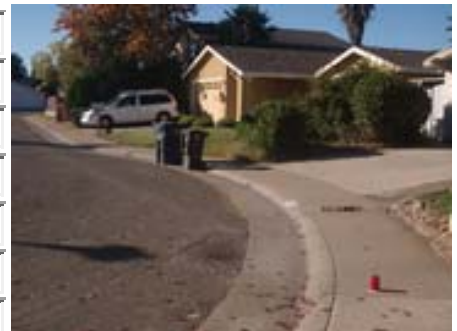
Barrier Type: Cross Slope - Existing (4.1% to 4.9%)

Description: Cross slope exceeds 2.0% (4.1% to 4.9%)

Bar. Severity: 2 Recommended Cost Estimate: \$32,000.00 Status:

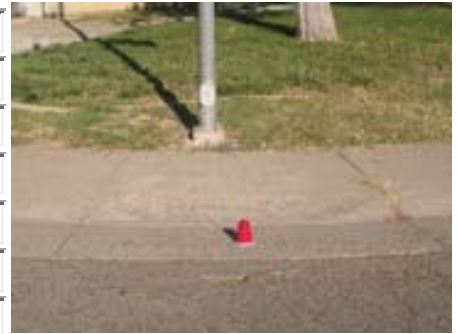
Barrier Type: No Curb Ramp - Depressed Existing Curb

Description: No compliant curb cut at corner (intersection)

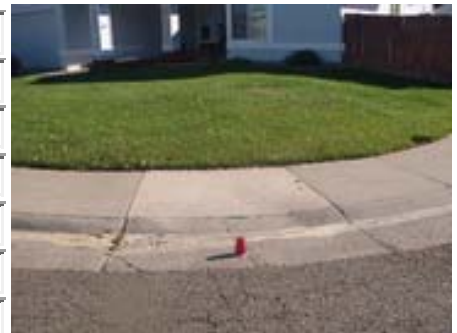
Barrier Type: No Curb Ramp - Depressed Existing Curb

Description: No compliant curb cut at corner (intersection)

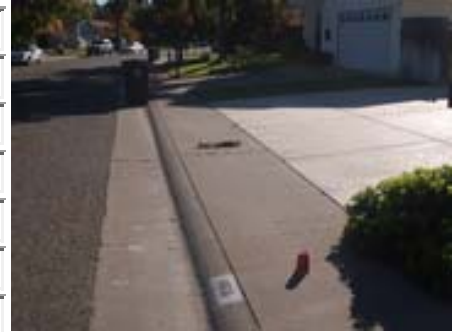
Barrier Type: Cross Slope - Existing (4.1% to 4.9%)

Description: Cross slope exceeds 2.0% (4.1% to 4.9%)

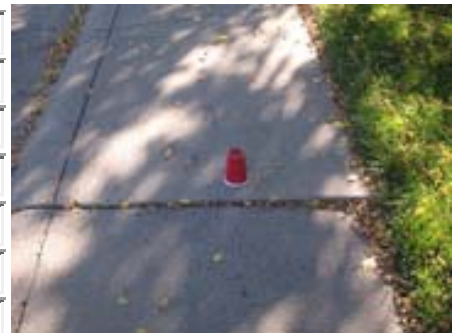
Barrier Type: Abrupt Change in Level - > 1/2"

Code Ref: CBC 1133B.7.1 and ADA/ABA 303.3

As Built Meas: 4 Quantity: LF

Description: Change in level greater than 1/2"

Solution: Grind or repair sidewalk to remove trip hazard

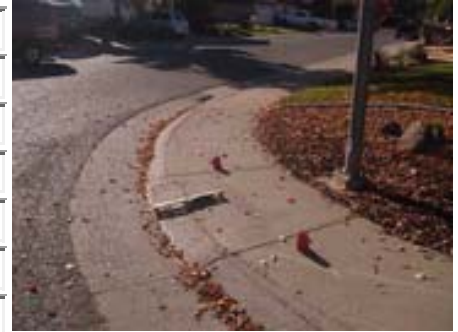
Barrier Type: Elbow in Sidewalk - Cross Slope (5.0% or more)

Code Ref: CBC 1133B.7.1.3 and ADA/ABA 403.3

As Built Meas: 6 Quantity: LF

Description: Cross slope at elbow exceeds 2.0% (5.0% or more)

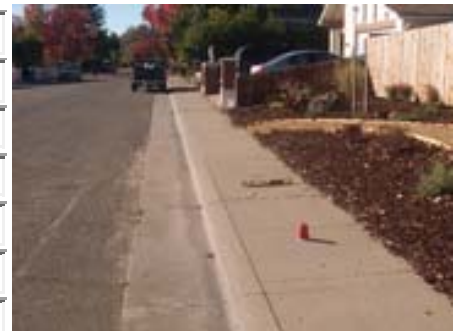
Barrier Type: Cross Slope - Existing (5.0% or more)

Code Ref: CBC 1133B.7.1.3 and ADA/ABA 403.3

As Built Meas: 493 Quantity: LF

Description: Cross slope exceeds 2.0% (5.0% or more)

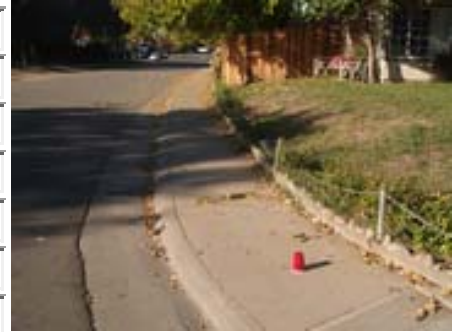
Barrier Type: Cross Slope - Existing (5.0% or more)

Code Ref: CBC 1133B.7.1.3 and ADA/ABA 403.3

As Built Meas: 179 Quantity: LF

Description: Cross slope exceeds 2.0% (5.0% or more)

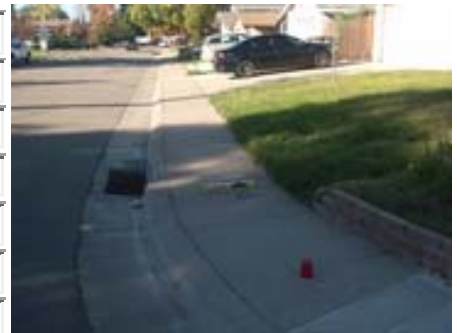
Barrier Type: Cross Slope - Existing (5.0% or more)

Code Ref: CBC 1133B.7.1.3 and ADA/ABA 403.3

As Built Meas: 711 Quantity: LF

Description: Cross slope exceeds 2.0% (5.0% or more)

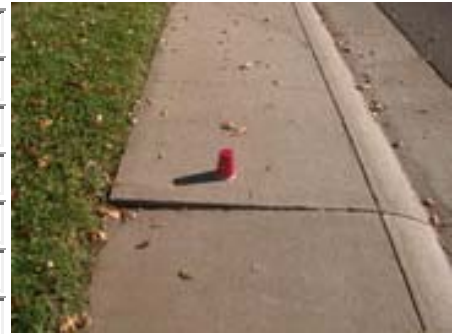
Barrier Type: Abrupt Change in Level - > 1/2"

Code Ref: CBC 1133B.7.1 and ADA/ABA 303.3

As Built Meas: 4 Quantity: LF

Description: Change in level greater than 1/2"

Solution: Grind or repair sidewalk to remove trip hazard

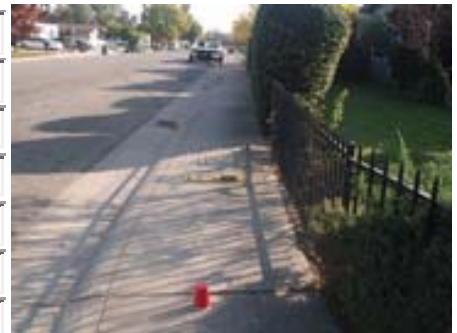
Barrier Type: Cross Slope - Existing (5.0% or more)

Code Ref: CBC 1133B.7.1.3 and ADA/ABA 403.3

As Built Meas: 173 Quantity: LF

Description: Cross slope exceeds 2.0% (5.0% or more)

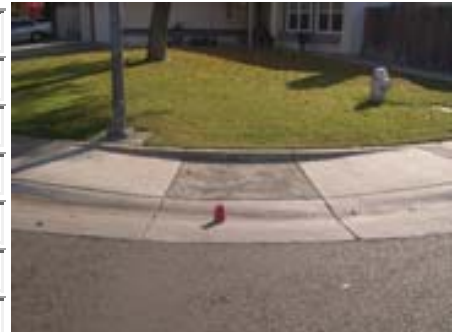
Barrier Type: 12" Grooves - Existing (3.1% to 4.0%)

Code Ref: CBC 1127B.5.6

As Built Meas: 1 Quantity: EACH

Description: 12" grooves at top of curb ramp are not level (3.1% to 4.0%)

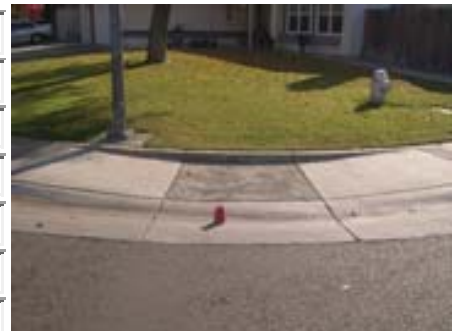
Barrier Type: Detectable Warnings - Truncated Domes

Code Ref: CBC 1127B.5.7 and ADA/ABA 705.1.3

As Built Meas: 1 Quantity: EACH

Description: No truncated domes provided at curb ramp

Bar. Severity: 2 Recommended Cost Estimate: \$0.00 Status:

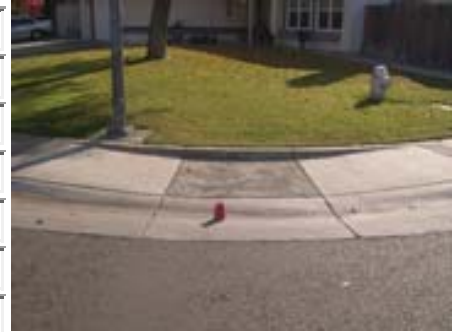
Barrier Type: Gutter Slope - Existing (6.6% to 8.2%)

Code Ref: CBC 1127B.5.3 and ADA/ABA 406.2

As Built Meas: 6 Quantity: SF

Description: Gutter slope exceeds 5.0% (6.6% to 8.2%)

Bar. Severity: 2 Recommended Cost Estimate: \$0.00 Status:

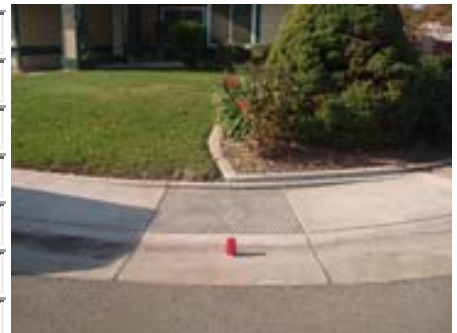
Barrier Type: Detectable Warnings - Truncated Domes

Code Ref: CBC 1127B.5.7 and ADA/ABA 705.1.3

As Built Meas: 1 Quantity: EACH

Description: No truncated domes provided at curb ramp

Bar. Severity: 2 Recommended Cost Estimate: \$1,400.00 Status:

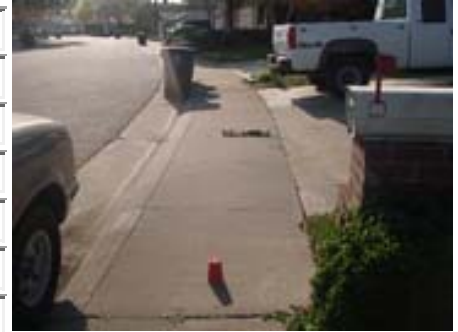
Barrier Type: Cross Slope - Existing (4.1% to 4.9%)

Code Ref: CBC 1133B.7.1.3 and ADA/ABA 403.3

As Built Meas: 364 Quantity: LF

Description: Cross slope exceeds 2.0% (4.1% to 4.9%)

Bar. Severity: 2 Recommended

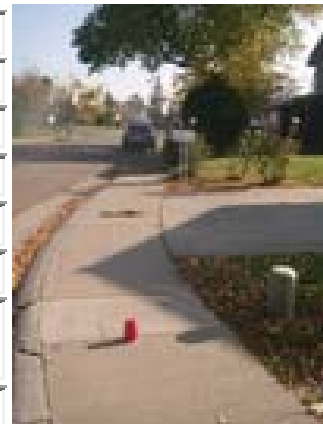
Barrier Type: Cross Slope - Existing (5.0% or more)

Code Ref: CBC 1133B.7.1.3 and ADA/ABA 403.3

As Built Meas: 433 Quantity: LF

Description: Cross slope exceeds 2.0% (5.0% or more)

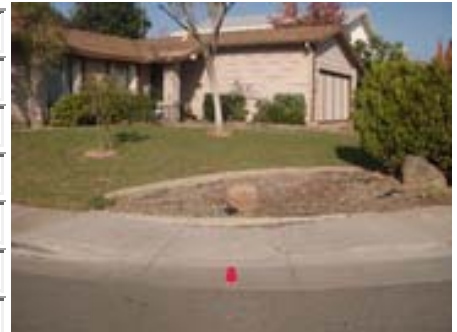
Barrier Type: 12" Grooves - Existing (>5.0%)

Code Ref: CBC 1127B.5.6

As Built Meas: 1 Quantity: EACH

Description: 12" grooves at top of curb ramp are not level (>5.0%)

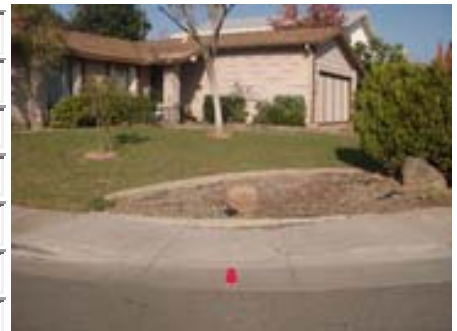
Barrier Type: Detectable Warnings - Truncated Domes

Code Ref: CBC 1127B.5.7 and ADA/ABA 705.1.3

As Built Meas: 1 Quantity: EACH

Description: No truncated domes provided at curb ramp

Bar. Severity: 2 Recommended Cost Estimate: \$0.00 Status:

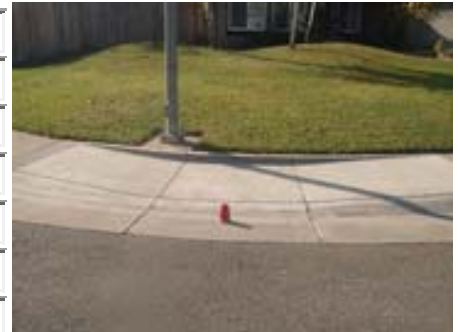
Barrier Type: Detectable Warnings - Truncated Domes

Code Ref: CBC 1127B.5.7 and ADA/ABA 705.1.3

As Built Meas: 1 Quantity: EACH

Description: No truncated domes provided at curb ramp

Bar. Severity: 2 Recommended Cost Estimate: \$1,400.00 Status:

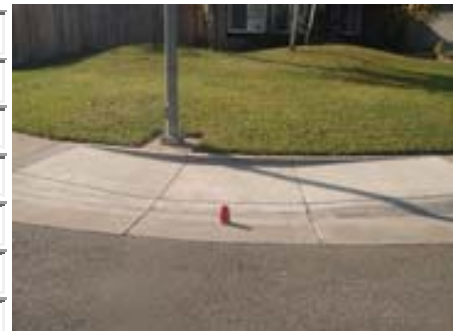
Barrier Type: Gutter Slope - Existing (8.3% or more)

Code Ref: CBC 1127B.5.3 and ADA/ABA 406.2

As Built Meas: 6 Quantity: SF

Description: Gutter slope exceeds 5.0% (8.3% or more)

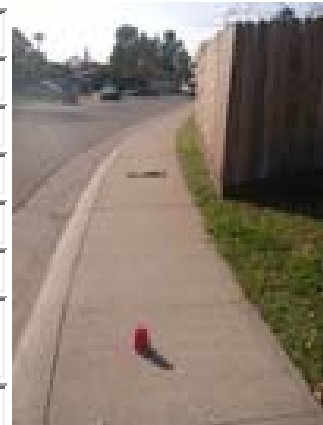
Barrier Type: Cross Slope - Existing (4.1% to 4.9%)

Code Ref: CBC 1133B.7.1.3 and ADA/ABA 403.3

As Built Meas: 169 Quantity: LF

Description: Cross slope exceeds 2.0% (4.1% to 4.9%)

Bar. Severity: 2 Recommended Cost Estimate: \$21,125.00 Status:

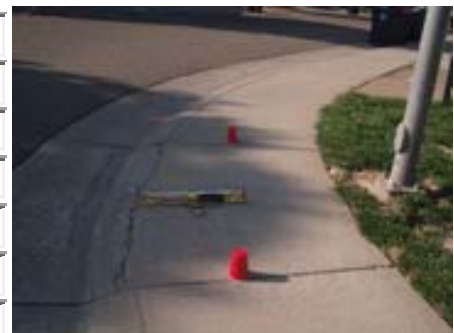
Barrier Type: Elbow in Sidewalk - Cross Slope (5.0% or more)

Code Ref: CBC 1133B.7.1.3 and ADA/ABA 403.3

As Built Meas: 8 Quantity: LF

Description: Cross slope at elbow exceeds 2.0% (5.0% or more)

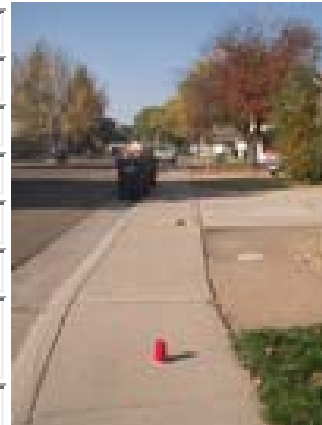
Barrier Type: Cross Slope - Existing (5.0% or more)

Code Ref: CBC 1133B.7.1.3 and ADA/ABA 403.3

As Built Meas: 453 Quantity: LF

Description: Cross slope exceeds 2.0% (5.0% or more)

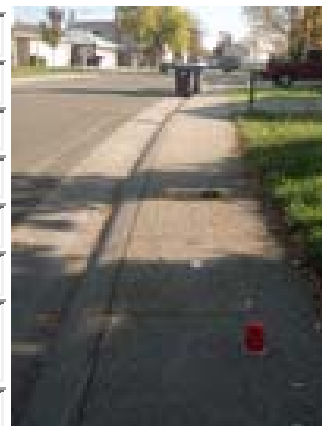
Barrier Type: Cross Slope - Existing (5.0% or more)

Code Ref: CBC 1133B.7.1.3 and ADA/ABA 403.3

As Built Meas: 477 Quantity: LF

Description: Cross slope exceeds 2.0% (5.0% or more)

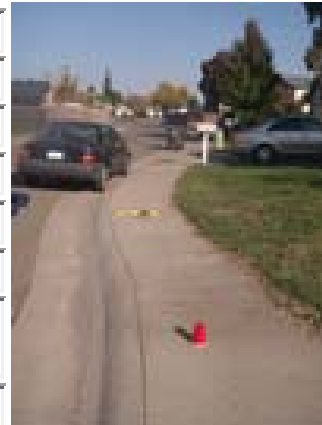
Barrier Type: Cross Slope - Existing (4.1% to 4.9%)

Code Ref: CBC 1133B.7.1.3 and ADA/ABA 403.3

As Built Meas: 447 Quantity: LF

Description: Cross slope exceeds 2.0% (4.1% to 4.9%)

Bar. Severity: 2 Recommended Cost Estimate: \$55,875.00 Status:

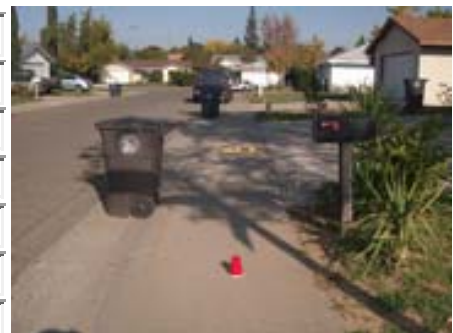
Barrier Type: Cross Slope - Existing (5.0% or more)

Code Ref: CBC 1133B.7.1.3 and ADA/ABA 403.3

As Built Meas: 194 Quantity: LF

Description: Cross slope exceeds 2.0% (5.0% or more)

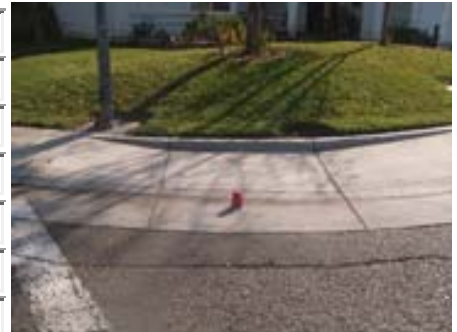
Barrier Type: 12" Grooves - Existing (3.1% to 4.0%)

Code Ref: CBC 1127B.5.6

As Built Meas: 1 Quantity: EACH

Description: 12" grooves at top of curb ramp are not level (3.1% to 4.0%)

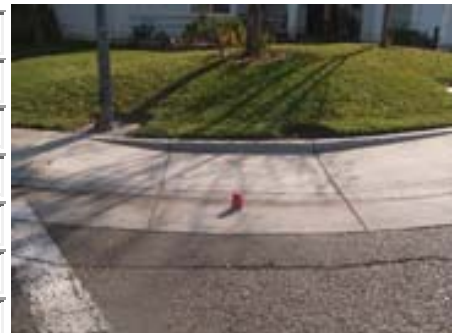
Barrier Type: Detectable Warnings - Truncated Domes

Code Ref: CBC 1127B.5.7 and ADA/ABA 705.1.3

As Built Meas: 1 Quantity: EACH

Description: No truncated domes provided at curb ramp

Bar. Severity: 2 Recommended Cost Estimate: \$0.00 Status:

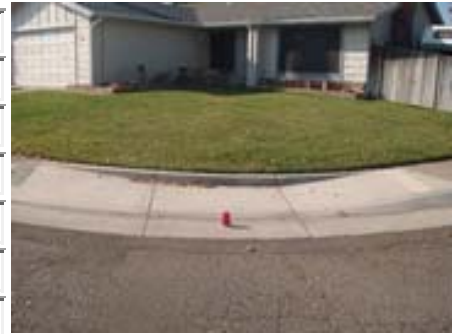
Barrier Type: 12" Grooves - Existing (3.1% to 4.0%)

Code Ref: CBC 1127B.5.6

As Built Meas: 1 Quantity: EACH

Description: 12" grooves at top of curb ramp are not level (3.1% to 4.0%)

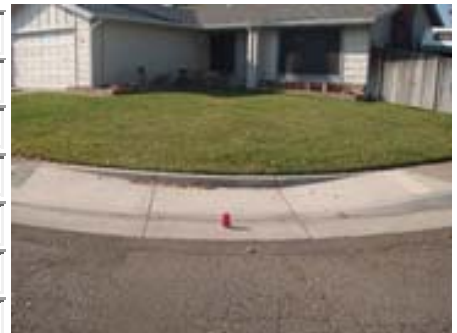
Barrier Type: Detectable Warnings - Truncated Domes

Code Ref: CBC 1127B.5.7 and ADA/ABA 705.1.3

As Built Meas: 1 Quantity: EACH

Description: No truncated domes provided at curb ramp

Bar. Severity: 2 Recommended

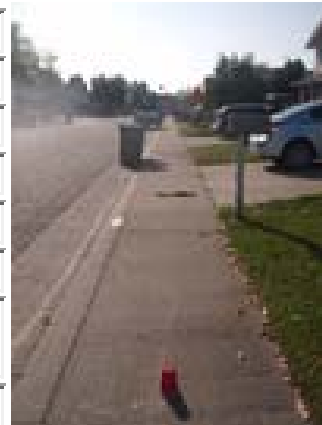
Barrier Type: Cross Slope - Existing (5.0% or more)

Code Ref: CBC 1133B.7.1.3 and ADA/ABA 403.3

As Built Meas: 250 Quantity: LF

Description: Cross slope exceeds 2.0% (5.0% or more)
