SZS CONSULTING GROUP

DRAFT ADA TRANSITION PLAN UPDATE
NEIGHBORHOOD AREA 3 CHANT
SEPTEMBER 20, 2011

CITY OF CITRUS HEIGHTS

Citrus Heights Area Three (CHANT)

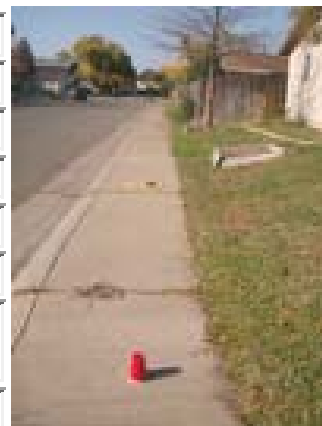
Barrier Type: Cross Slope - Existing (5.0% or more)

Code Ref: CBC 1133B.7.1.3 and ADA/ABA 403.3

As Built Meas: 162 Quantity: LF

Description: Cross slope exceeds 2.0% (5.0% or more)

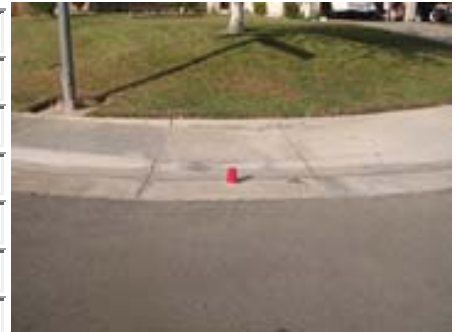
Barrier Type: Detectable Warnings - Truncated Domes

Code Ref: CBC 1127B.5.7 and ADA/ABA 705.1.3

As Built Meas: 1 Quantity: EACH

Description: No truncated domes provided at curb ramp

Bar. Severity: 2 Recommended Cost Estimate: \$1,400.00 Status:

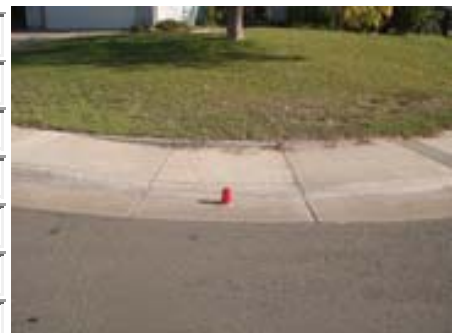
Barrier Type: Detectable Warnings - Truncated Domes

Code Ref: CBC 1127B.5.7 and ADA/ABA 705.1.3

As Built Meas: 1 Quantity: EACH

Description: No truncated domes provided at curb ramp

Bar. Severity: 2 Recommended Cost Estimate: \$1,400.00 Status:

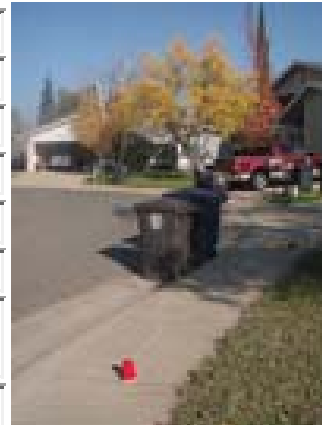
Barrier Type: Cross Slope - Existing (5.0% or more)

Code Ref: CBC 1133B.7.1.3 and ADA/ABA 403.3

As Built Meas: 97 Quantity: LF

Description: Cross slope exceeds 2.0% (5.0% or more)

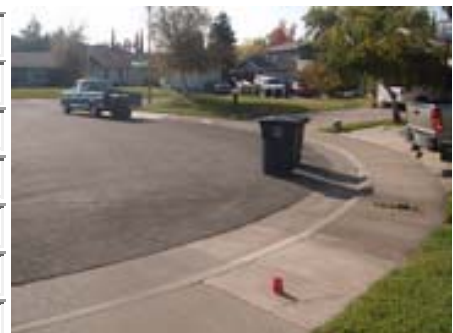
Barrier Type: Cross Slope - Existing (3.1% to 4.0%)

Code Ref: CBC 1133B.7.1.3 and ADA/ABA 403.3

As Built Meas: 77 Quantity: LF

Description: Cross slope exceeds 2.0% (3.1% to 4.0%)

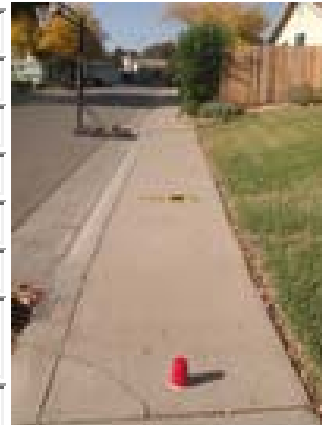
Barrier Type: Cross Slope - Existing (5.0% or more)

Code Ref: CBC 1133B.7.1.3 and ADA/ABA 403.3

As Built Meas: 172 Quantity: LF

Description: Cross slope exceeds 2.0% (5.0% or more)

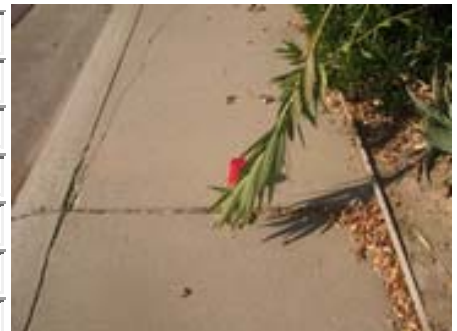
Barrier Type: Abrupt Change in Level - > 1/2"

Code Ref: CBC 1133B.7.1 and ADA/ABA 303.3

As Built Meas: 4 Quantity: LF

Description: Change in level greater than 1/2"

Solution: Grind or repair sidewalk to remove trip hazard

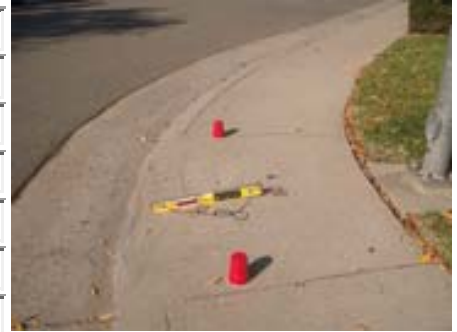
Barrier Type: Elbow in Sidewalk - Cross Slope (5.0% or more)

Code Ref: CBC 1133B.7.1.3 and ADA/ABA 403.3

As Built Meas: 8 Quantity: LF

Description: Cross slope at elbow exceeds 2.0% (5.0% or more)

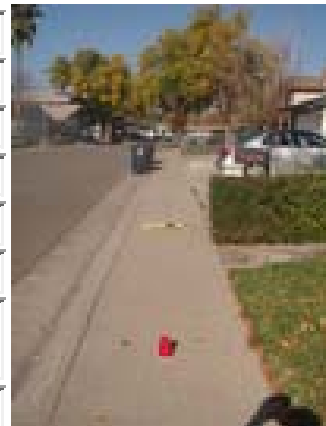
Barrier Type: Cross Slope - Existing (4.1% to 4.9%)

Code Ref: CBC 1133B.7.1.3 and ADA/ABA 403.3

As Built Meas: 318 Quantity: LF

Description: Cross slope exceeds 2.0% (4.1% to 4.9%)

Bar. Severity: 2 Recommended Cost Estimate: \$39,750.00 Status:

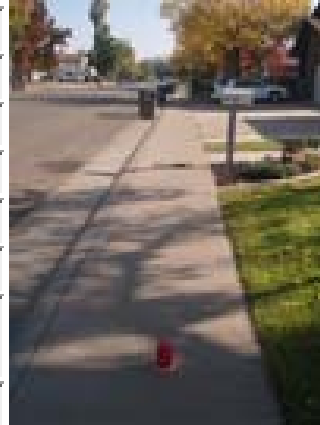
Barrier Type: Cross Slope - Existing (3.1% to 4.0%)

Code Ref: CBC 1133B.7.1.3 and ADA/ABA 403.3

As Built Meas: 556 Quantity: LF

Description: Cross slope exceeds 2.0% (3.1% to 4.0%)

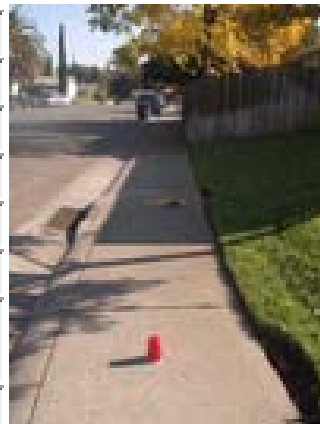
Barrier Type: Cross Slope - Existing (3.1% to 4.0%)

Code Ref: CBC 1133B.7.1.3 and ADA/ABA 403.3

As Built Meas: 428 Quantity: LF

Description: Cross slope exceeds 2.0% (3.1% to 4.0%)

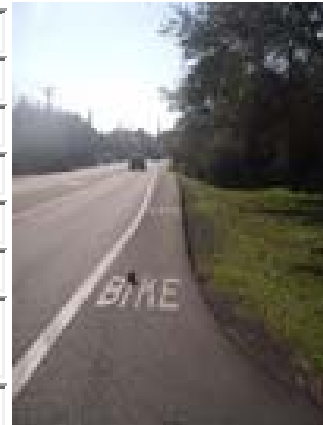
Barrier Type: Drop-off Along Ped Route (> 4")

Code Ref: CBC 1133B.8.1

As Built Meas: 1313 Quantity: LF

Description: Drop of more than 4" along pedestrian route lacks warning curb

As Built Desc: 7" drop off creates hazardous condition for the visually impaired

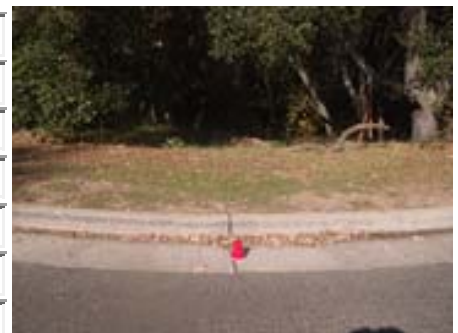
Barrier Type: Detectable Warnings - Truncated Domes

Description: No truncated domes provided at transition into roadway

Bar. Severity: 2 Recommended Cost Estimate: \$1,400.00 Status:

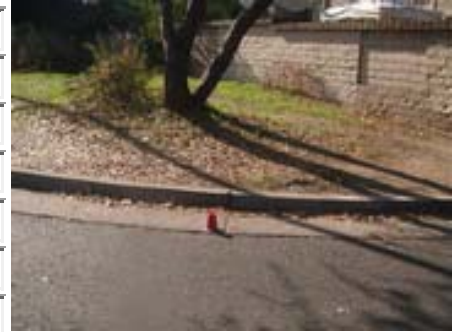
Barrier Type: Detectable Warnings - Truncated Domes

Description: No truncated domes provided at transition into roadway

Bar. Severity: 2 Recommended Cost Estimate: \$1,400.00 Status:

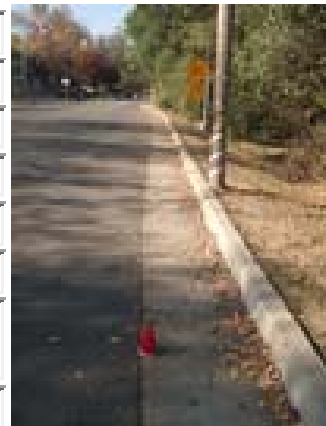
Barrier Type: Shoulder Cross Slope - Existing (5.0% or more)

Description: Cross slope exceeds 2.0% (5.0% or more)

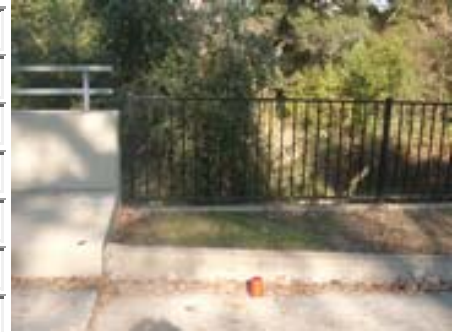
Barrier Type: No Sidewalk - Transition to Shoulder

Description: Sidewalk ends and no ramp to pedestrian shoulder is provided

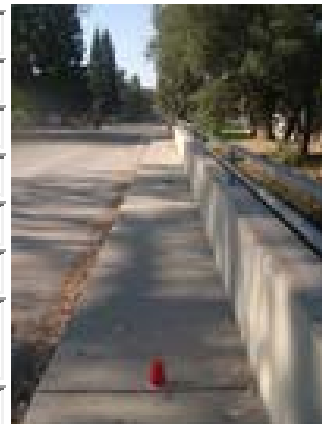
Barrier Type: Cross Slope - Existing (4.1% to 4.9%)

Description: Cross slope exceeds 2.0% (4.1% to 4.9%)

Bar. Severity: 2 Recommended Cost Estimate: \$14,875.00 Status:

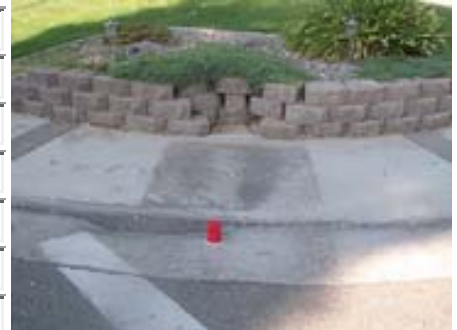
Barrier Type: Detectable Warnings - Truncated Domes

Description: No truncated domes provided at curb ramp

Bar. Severity: 2 Recommended Cost Estimate: \$1,400.00 Status:

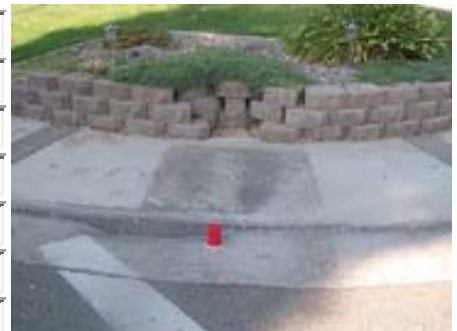
Barrier Type: Lip - Bottom of Ramp at Flow Line

Description: Transition at ramp bottom (flow line) is not flush and free of any lip

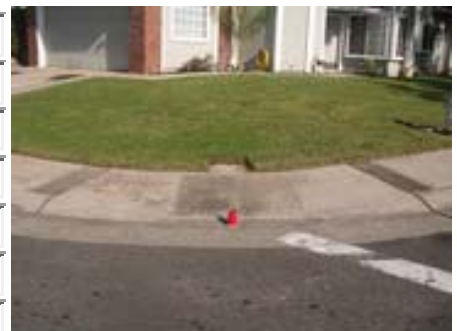
Barrier Type: 12" Grooves - Existing (4.1% to 4.9%)

Description: 12" grooves at top of curb ramp are not level (4.1% to 4.9%)

Bar. Severity: 2 Recommended Cost Estimate: \$2,500.00 Status:

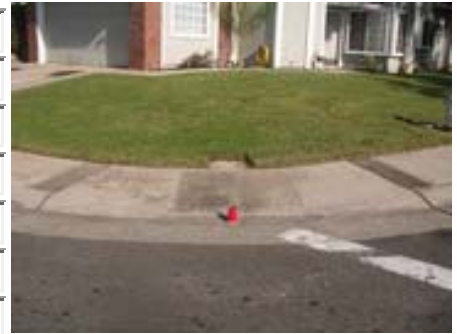
Barrier Type: Parallel Ramp Landing - Existing (3.1% to 4.0%)

Description: Curb ramp landing or pan not level (3.1% to 4.0%)

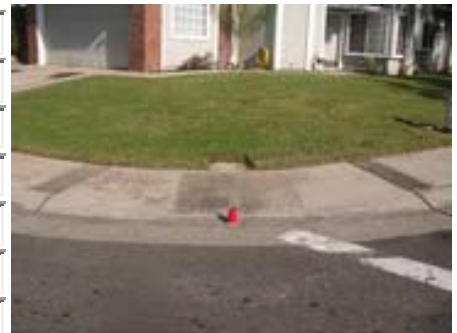
Barrier Type: Detectable Warnings - Truncated Domes

Description: No truncated domes provided at curb ramp

Bar. Severity: 2 Recommended Cost Estimate: \$0.00 Status:

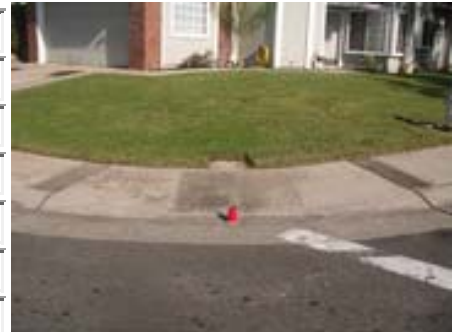
Barrier Type: Gutter Slope - Existing (6.6% to 8.2%)

Description: Gutter slope exceeds 5.0% (6.6% to 8.2%)

Bar. Severity: 2 Recommended Cost Estimate: \$0.00 Status:

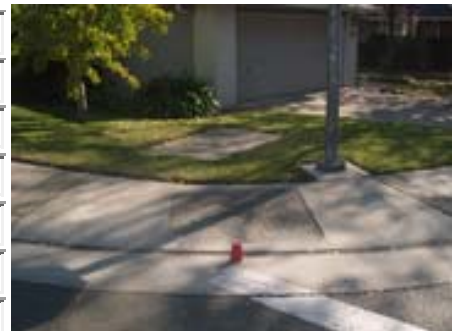
Barrier Type: 12" Grooves - Existing (>5.0%)

Description: 12" grooves at top of curb ramp are not level (>5.0%)

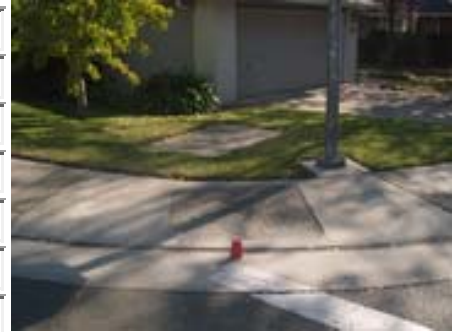
Barrier Type: Parallel Ramp Landing - Existing (3.1% to 4.0%)

Description: Curb ramp landing or pan not level (3.1% to 4.0%)

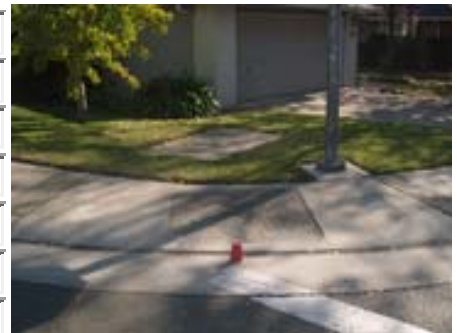
Barrier Type: Detectable Warnings - Truncated Domes

Description: No truncated domes provided at curb ramp

Bar. Severity: 2 Recommended Cost Estimate: \$0.00 Status:

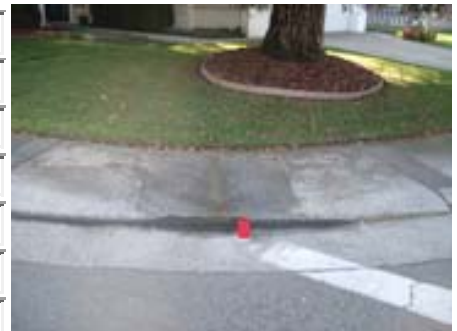
Barrier Type: Detectable Warnings - Truncated Domes

Description: No truncated domes provided at curb ramp

Bar. Severity: 2 Recommended Cost Estimate: \$1,400.00 Status:

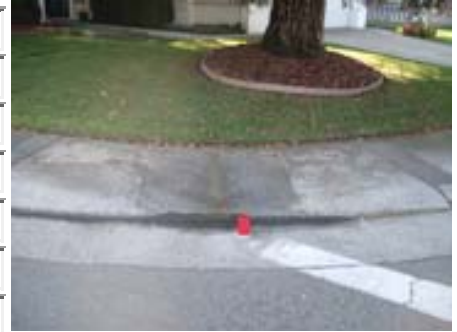
Barrier Type: Gutter Slope - Existing (5.1% - 5.8%)

Description: Gutter slope exceeds 5.0% (5.1% - 5.8%)

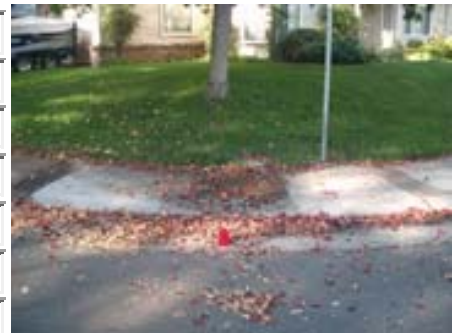
Barrier Type: Detectable Warnings - Truncated Domes

Description: No truncated domes provided at curb ramp

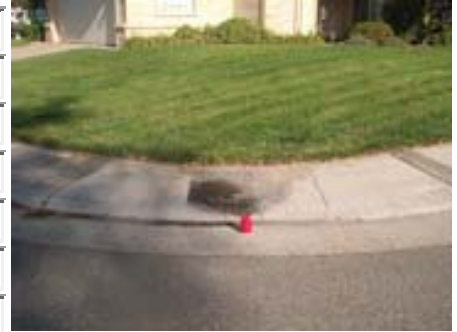
Barrier Type: 12" Grooves - Existing (4.1% to 4.9%)

Description: 12" grooves at top of curb ramp are not level (4.1% to 4.9%)

Bar. Severity: 2 Recommended Cost Estimate: \$2,500.00 Status:

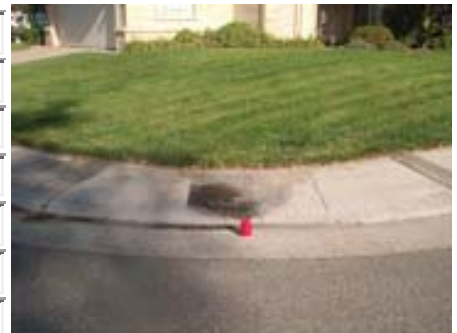
Barrier Type: Parallel Ramp Landing - Existing (3.1% to 4.0%)

Description: Curb ramp landing or pan not level (3.1% to 4.0%)

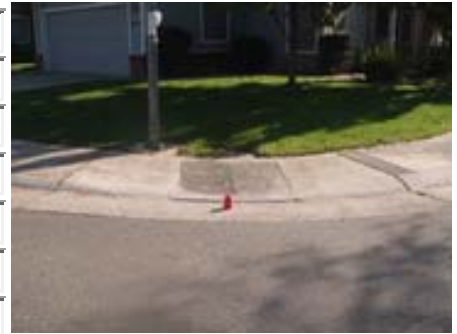
Barrier Type: 12" Grooves - Existing (3.1% to 4.0%)

Description: 12" grooves at top of curb ramp are not level (3.1% to 4.0%)

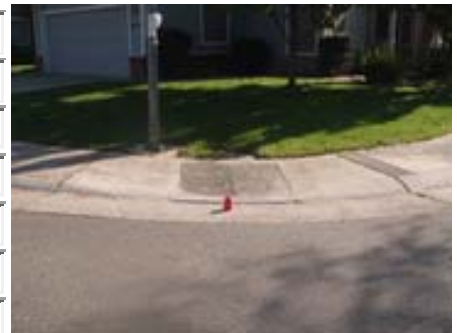
Barrier Type: Detectable Warnings - Truncated Domes

Description: No truncated domes provided at curb ramp

Bar. Severity: 2 Recommended Cost Estimate: \$0.00 Status:

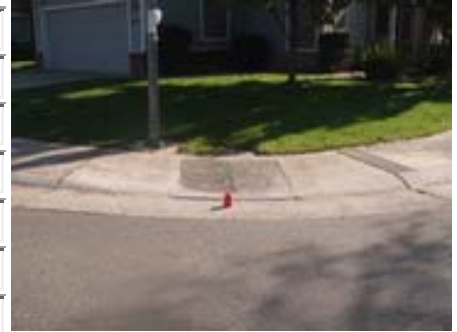
Barrier Type: Lip - Bottom of Ramp at Flow Line

Description: Transition at ramp bottom (flow line) is not flush and free of any lip

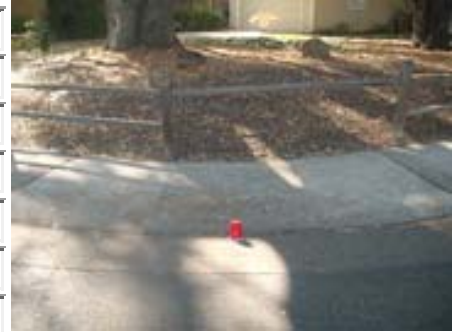
Barrier Type: 12" Grooves - Existing (4.1% to 4.9%)

Description: 12" grooves at top of curb ramp are not level (4.1% to 4.9%)

Bar. Severity: 2 Recommended Cost Estimate: \$2,500.00 Status:

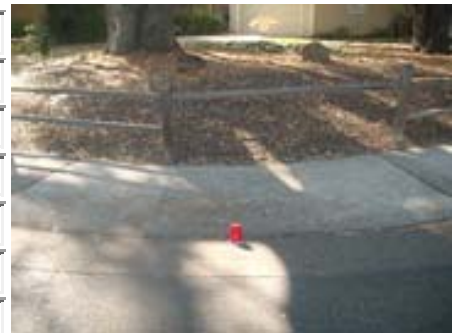
Barrier Type: Parallel Ramp Landing - Existing (3.1% to 4.0%)

Description: Curb ramp landing or pan not level (3.1% to 4.0%)

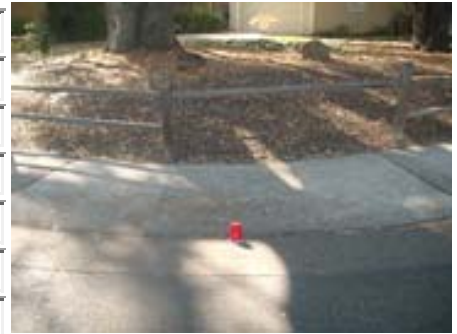
Barrier Type: Detectable Warnings - Truncated Domes

Description: No truncated domes provided at curb ramp

Bar. Severity: 2 Recommended Cost Estimate: \$0.00 Status:

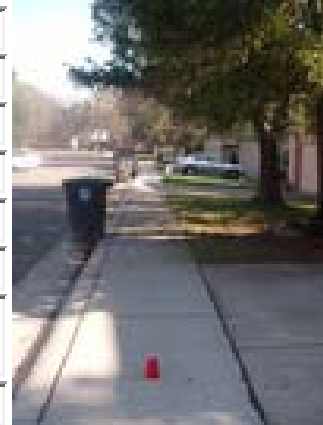
Barrier Type: Cross Slope - Existing (3.1% to 4.0%)

Description: Cross slope exceeds 2.0% (3.1% to 4.0%)

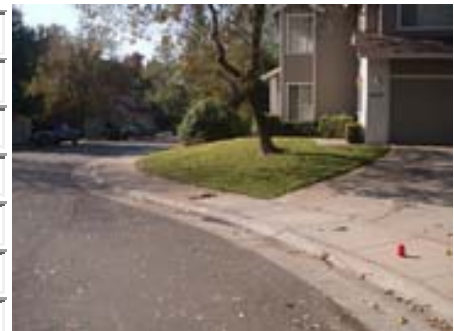
Barrier Type: Cross Slope - Existing (3.1% to 4.0%)

Description: Cross slope exceeds 2.0% (3.1% to 4.0%)

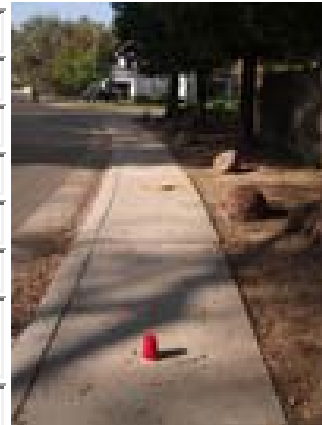
Barrier Type: Cross Slope - Existing (3.1% to 4.0%)

Description: Cross slope exceeds 2.0% (3.1% to 4.0%)

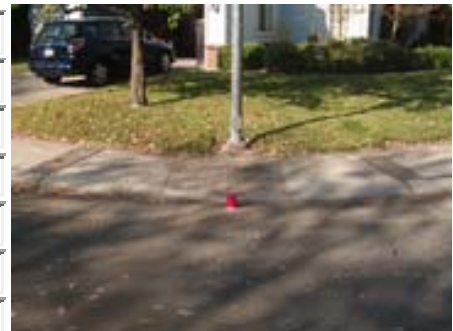
Barrier Type: Detectable Warnings - Truncated Domes

Description: No truncated domes provided at curb ramp

Bar. Severity: 2 Recommended Cost Estimate: \$1,400.00 Status:

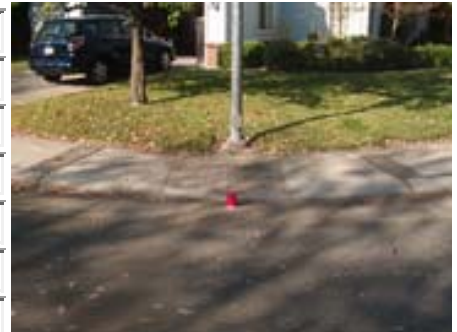
Barrier Type: Gutter Slope - Existing (6.6% to 8.2%)

Description: Gutter slope exceeds 5.0% (6.6% to 8.2%)

Bar. Severity: 2 Recommended Cost Estimate: \$750.00 Status:

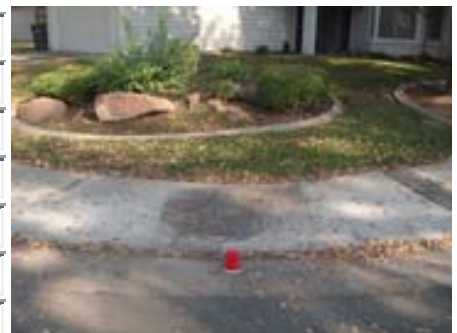
Barrier Type: Detectable Warnings - Truncated Domes

Description: No truncated domes provided at curb ramp

Bar. Severity: 2 Recommended Cost Estimate: \$1,400.00 Status:

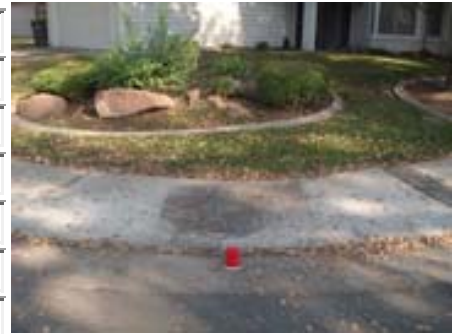
Barrier Type: Lip - Bottom of Ramp at Flow Line

Description: Transition at ramp bottom (flow line) is not flush and free of any lip

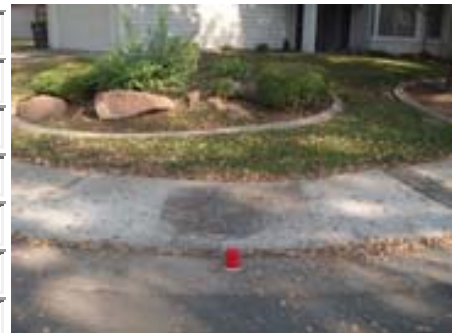
Barrier Type: Gutter Slope - Existing (5.9% - 6.5%)

Description: Gutter slope exceeds 5.0% (5.9% - 6.5%)

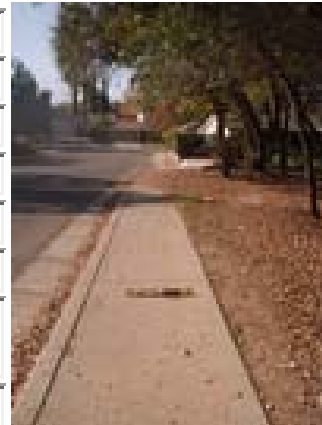
Barrier Type: Cross Slope - Existing (4.1% to 4.9%)

Description: Cross slope exceeds 2.0% (4.1% to 4.9%)

Bar. Severity: 2 Recommended Cost Estimate: \$21,875.00 Status:

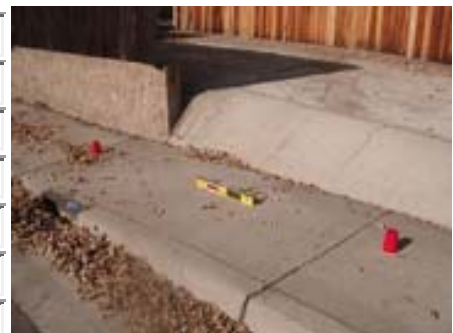
Barrier Type: Running Slope (Existing)

Description: Running slope exceeds 5.0%

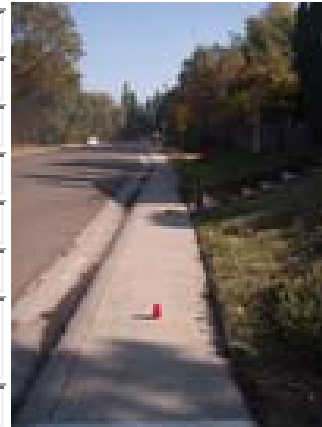
Barrier Type: Cross Slope - Existing (5.0% or more)

Description: Cross slope exceeds 2.0% (5.0% or more)

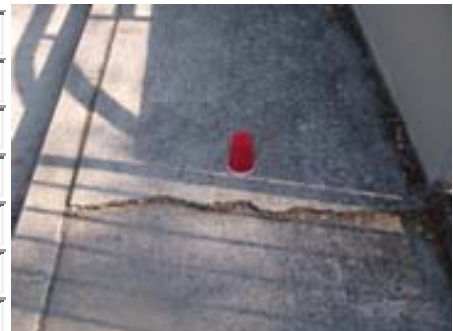
Barrier Type: Abrupt Change in Level - > 1/2"

Description: Change in level greater than 1/2"

Solution: Grind or repair sidewalk to remove trip hazard

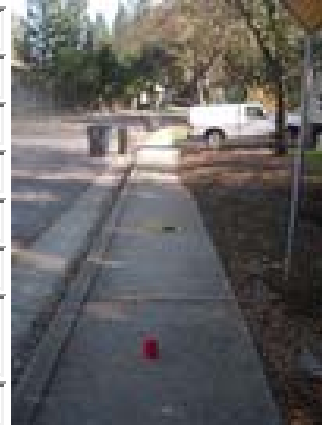
Barrier Type: Cross Slope - Existing (4.1% to 4.9%)

Description: Cross slope exceeds 2.0% (4.1% to 4.9%)

Bar. Severity: 2 Recommended

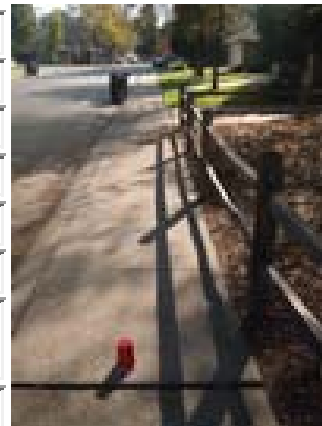
Barrier Type: Cross Slope - Existing (3.1% to 4.0%)

Description: Cross slope exceeds 2.0% (3.1% to 4.0%)

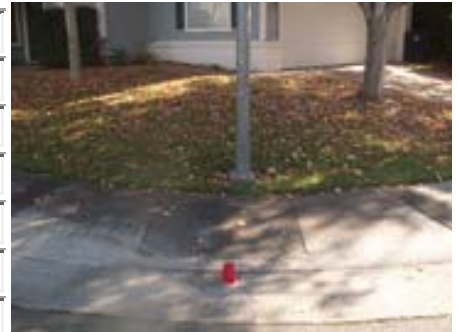
Barrier Type: Detectable Warnings - Truncated Domes

Description: No truncated domes provided at curb ramp

Bar. Severity: 2 Recommended Cost Estimate: \$1,400.00 Status:

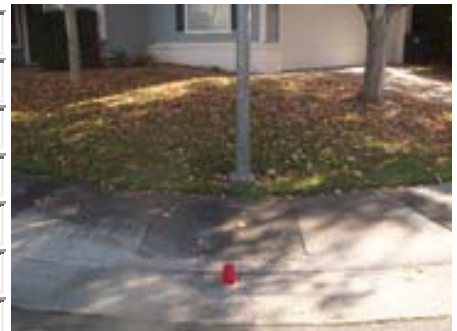
Barrier Type: Lip - Bottom of Ramp at Flow Line

Description: Transition at ramp bottom (flow line) is not flush and free of any lip

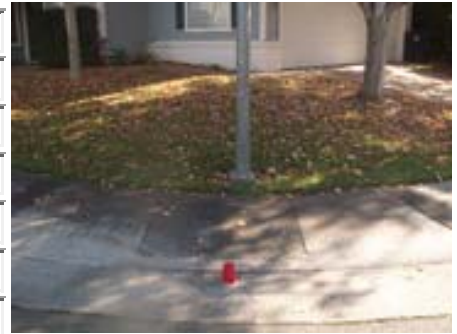
Barrier Type: Gutter Slope - Existing (6.6% to 8.2%)

Description: Gutter slope exceeds 5.0% (6.6% to 8.2%)

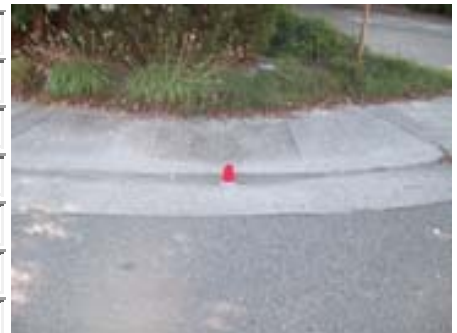
Barrier Type: Detectable Warnings - Truncated Domes

Description: No truncated domes provided at curb ramp

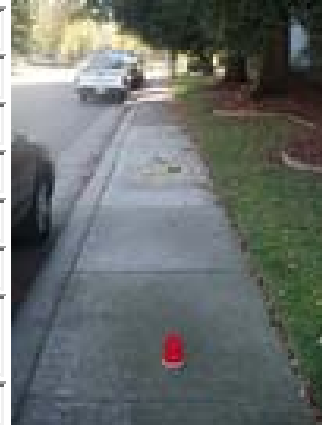
Barrier Type: Cross Slope - Existing (4.1% to 4.9%)

Description: Cross slope exceeds 2.0% (4.1% to 4.9%)

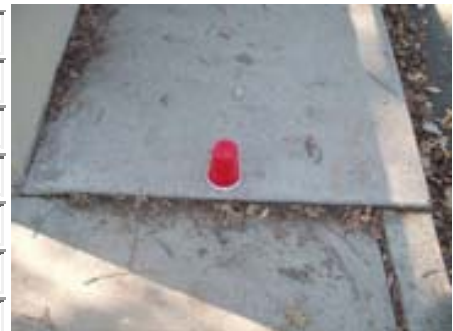
Barrier Type: Abrupt Change in Level - > 1/2"

Description: Change in level greater than 1/2"

Solution: Grind or repair sidewalk to remove trip hazard

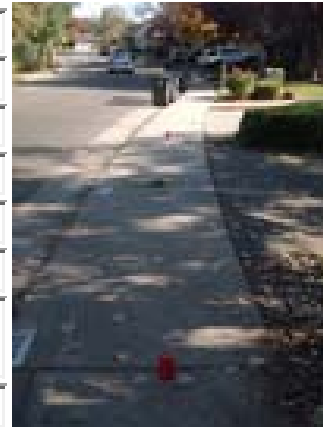
Barrier Type: Driveway - Existing (5.0% or more)

Description: Driveway cross slope exceeds 2.0% (5.0% or more)

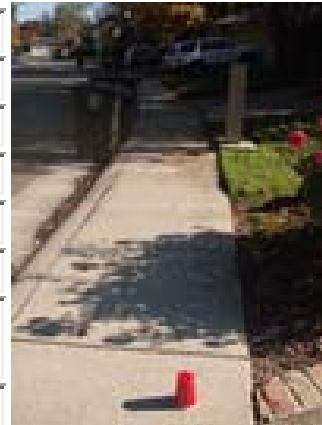
Barrier Type: Cross Slope - Existing (3.1% to 4.0%)

Description: Cross slope exceeds 2.0% (3.1% to 4.0%)

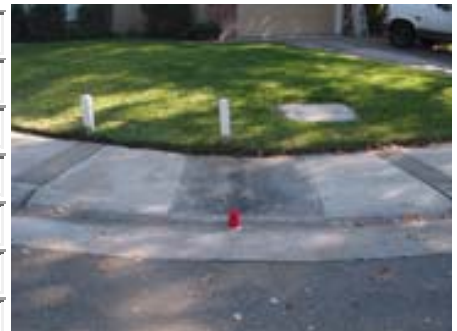
Barrier Type: Parallel Ramp Landing - Existing (4.1% to 4.9%)

Description: Curb ramp landing or pan not level(4.1% to 4.9%)

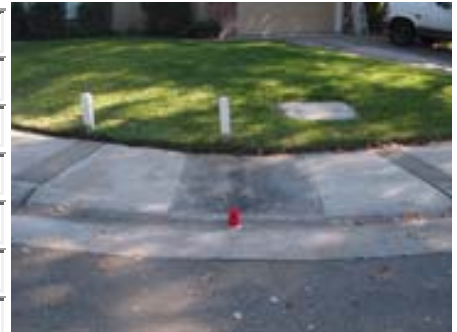
Barrier Type: Detectable Warnings - Truncated Domes

Description: No truncated domes provided at curb ramp

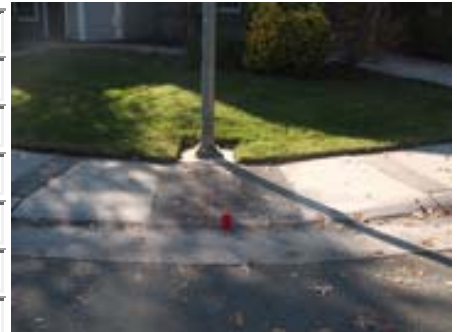
Barrier Type: Running Slope - Existing (9.0% to 9.4%)

Description: Ramp run cross slope exceeds 2.0% (9.0% to 9.4%)

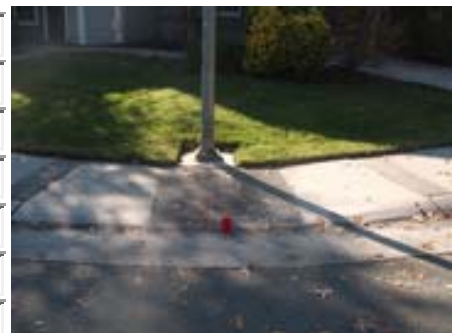
Barrier Type: Detectable Warnings - Truncated Domes

Description: No truncated domes provided at curb ramp

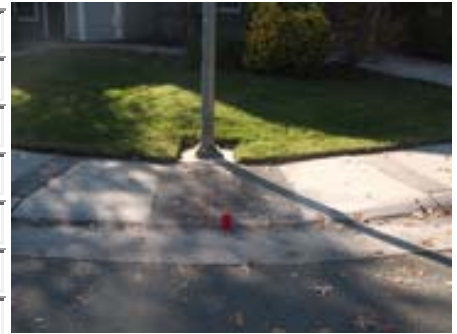
Barrier Type: Gutter Slope - Existing (5.1% - 5.8%)

Description: Gutter slope exceeds 5.0% (5.1% - 5.8%)

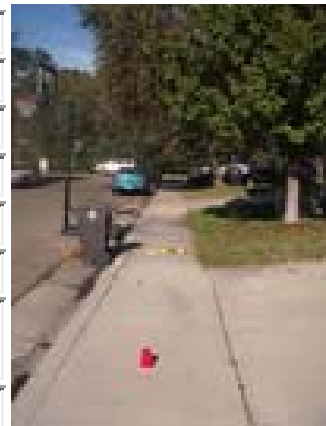
Barrier Type: Cross Slope - Existing (4.1% to 4.9%)

Description: Cross slope exceeds 2.0% (4.1% to 4.9%)

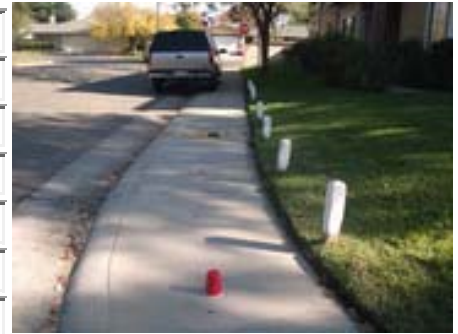
Barrier Type: Cross Slope - New Construction

Description: Cross slope exceeds 2.0% in new construction

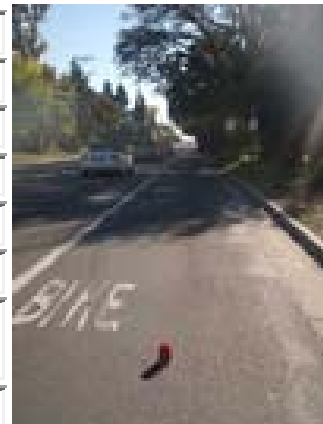
Barrier Type: Shoulder Cross Slope - Existing (3.1% to 4.0%)

Description: Cross slope exceeds 2.0% (3.1% to 4.0%)

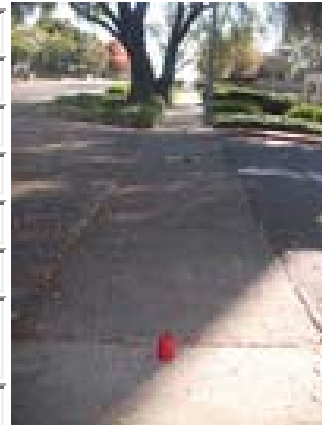
Barrier Type: Cross Slope - Existing (4.1% to 4.9%)

Description: Cross slope exceeds 2.0% (4.1% to 4.9%)

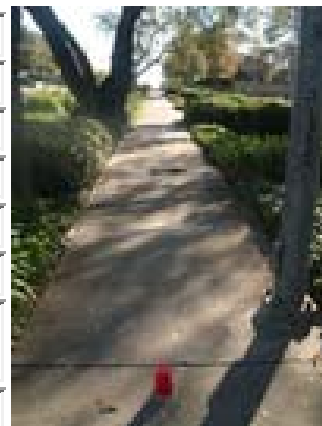
Barrier Type: Cross Slope - Existing (5.0% or more)

Description: Cross slope exceeds 2.0% (5.0% or more)

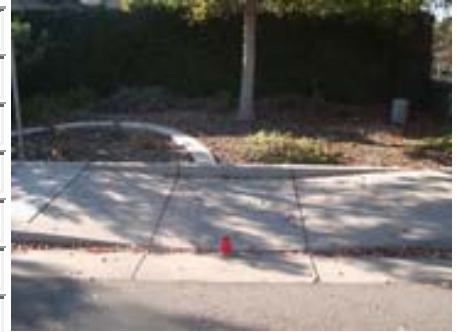
Barrier Type: Detectable Warnings - Truncated Domes

Description: No truncated domes provided at curb ramp

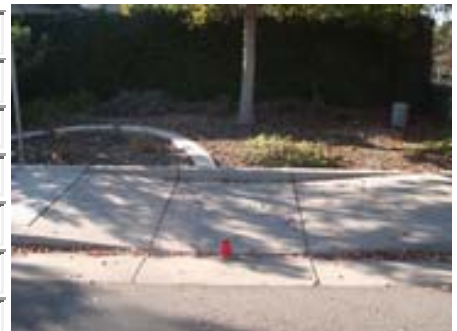
Barrier Type: Lip - Bottom of Ramp at Flow Line

Description: Transition at ramp bottom (flow line) is not flush and free of any lip

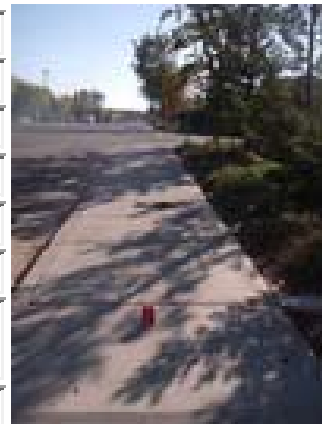
Barrier Type: Cross Slope - Existing (4.1% to 4.9%)

Description: Cross slope exceeds 2.0% (4.1% to 4.9%)

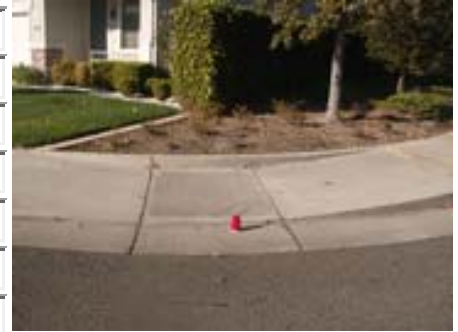
Barrier Type: Detectable Warnings - Truncated Domes

Description: No truncated domes provided at curb ramp

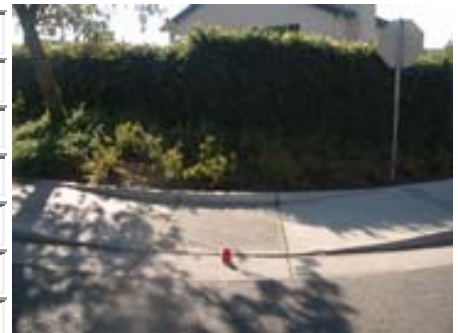
Barrier Type: Detectable Warnings - Truncated Domes

Description: No truncated domes provided at curb ramp

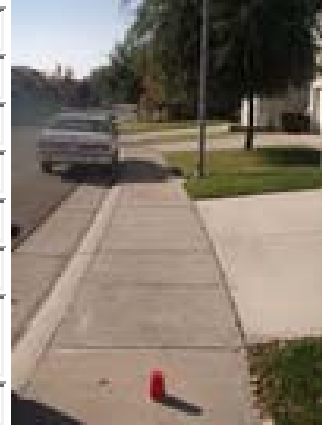
Barrier Type: Cross Slope - Existing (3.1% to 4.0%)

Description: Cross slope exceeds 2.0% (3.1% to 4.0%)

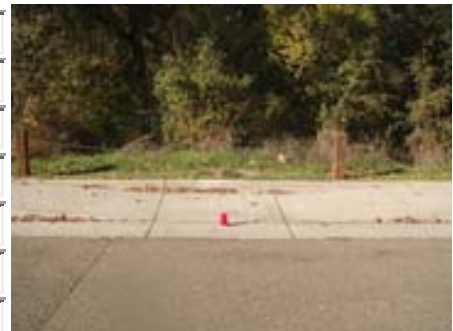
Barrier Type: Detectable Warnings - Truncated Domes

Description: No truncated domes provided at curb ramp

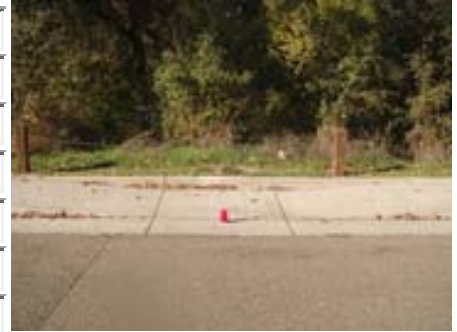
Barrier Type: Gutter Slope - Existing (6.6% to 8.2%)

Description: Gutter slope exceeds 5.0% (6.6% to 8.2%)

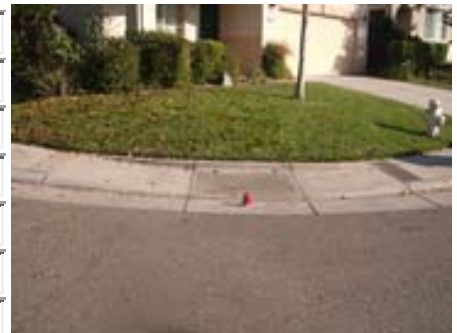
Barrier Type: Detectable Warnings - Truncated Domes

Description: No truncated domes provided at curb ramp

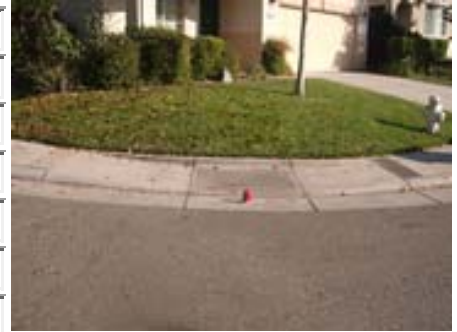
Barrier Type: Gutter Slope - Existing (5.9% - 6.5%)

Description: Gutter slope exceeds 5.0% (5.9% - 6.5%)

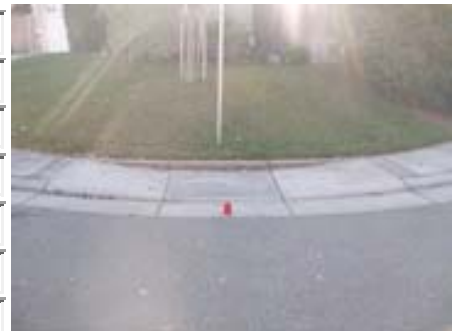
Barrier Type: Detectable Warnings - Truncated Domes

Description: No truncated domes provided at curb ramp

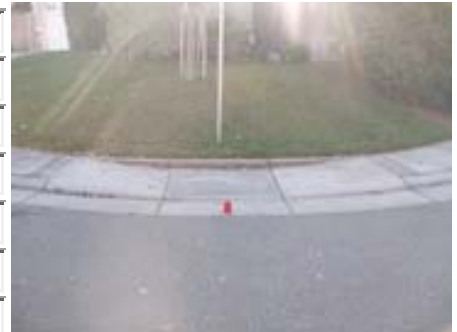
Barrier Type: Gutter Slope - Existing (6.6% to 8.2%)

Description: Gutter slope exceeds 5.0% (6.6% to 8.2%)

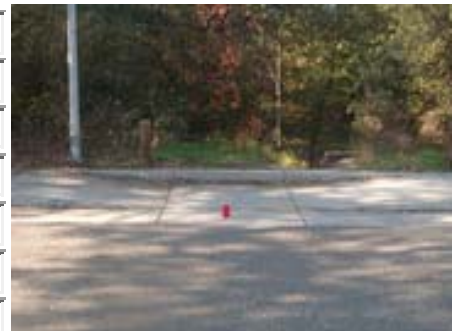
Barrier Type: Detectable Warnings - Truncated Domes

Description: No truncated domes provided at curb ramp

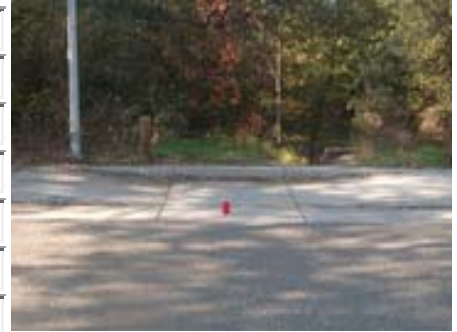
Barrier Type: Gutter Slope - Existing (6.6% to 8.2%)

Description: Gutter slope exceeds 5.0% (6.6% to 8.2%)

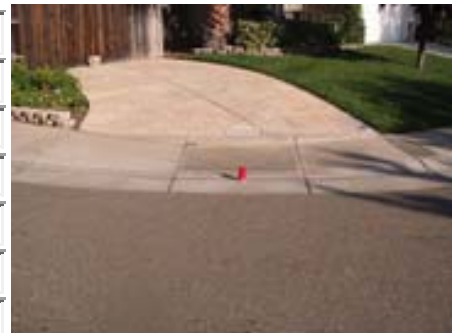
Barrier Type: Detectable Warnings - Truncated Domes

Description: No truncated domes provided at curb ramp

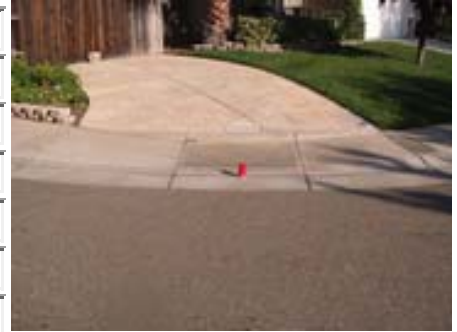
Barrier Type: Gutter Slope - Existing (6.6% to 8.2%)

Description: Gutter slope exceeds 5.0% (6.6% to 8.2%)

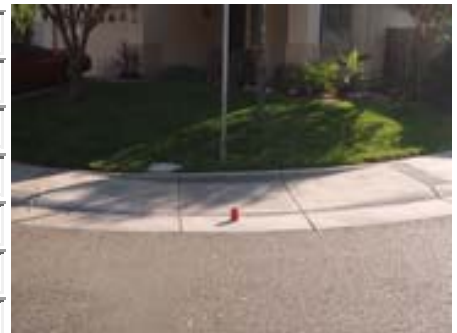
Barrier Type: Detectable Warnings - Truncated Domes

Description: No truncated domes provided at curb ramp

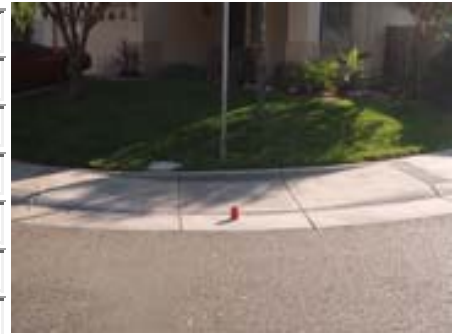
Barrier Type: Gutter Slope - Existing (5.9% - 6.5%)

Description: Gutter slope exceeds 5.0% (5.9% - 6.5%)

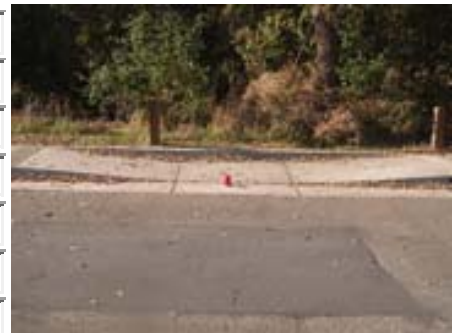
Barrier Type: Detectable Warnings - Truncated Domes

Description: No truncated domes provided at curb ramp

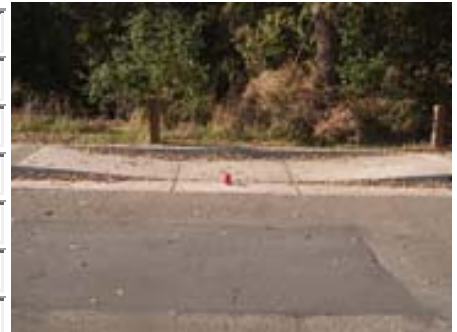
Barrier Type: Gutter Slope - Existing (5.9% - 6.5%)

Description: Gutter slope exceeds 5.0% (5.9% - 6.5%)

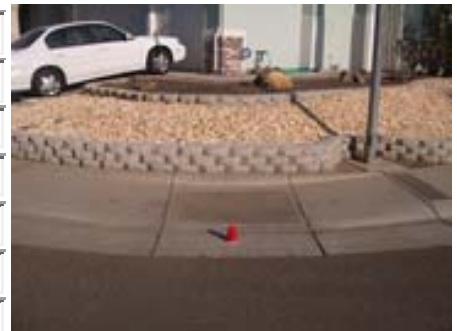
Barrier Type: Detectable Warnings - Truncated Domes

Description: No truncated domes provided at curb ramp

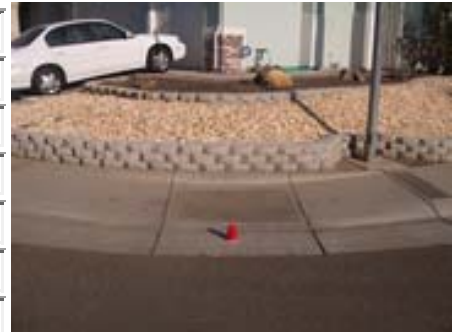
Barrier Type: Gutter Slope - Existing (5.9% - 6.5%)

Description: Gutter slope exceeds 5.0% (5.9% - 6.5%)

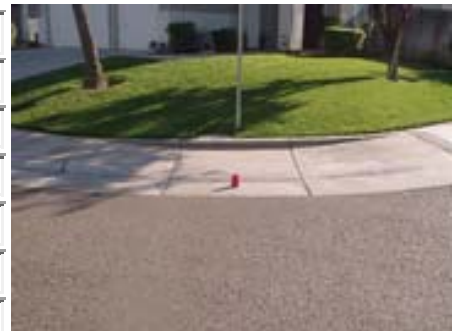
Barrier Type: Detectable Warnings - Truncated Domes

Description: No truncated domes provided at curb ramp

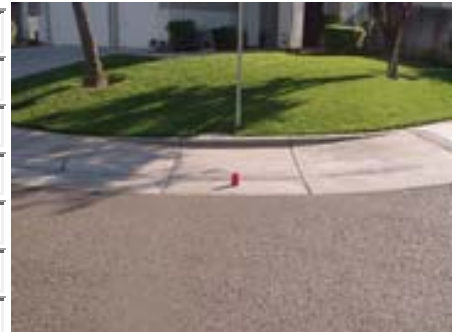
Barrier Type: Gutter Slope - Existing (5.9% - 6.5%)

Code Ref: CBC 1127B.5.3 and ADA/ABA 406.2

As Built Meas: 6 Quantity: SF

Description: Gutter slope exceeds 5.0% (5.9% - 6.5%)

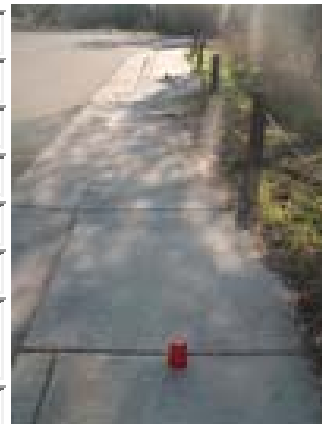
Barrier Type: Cross Slope - Existing (5.0% or more)

Code Ref: CBC 1133B.7.1.3 and ADA/ABA 403.3

As Built Meas: 23 Quantity: LF

Description: Cross slope exceeds 2.0% (5.0% or more)

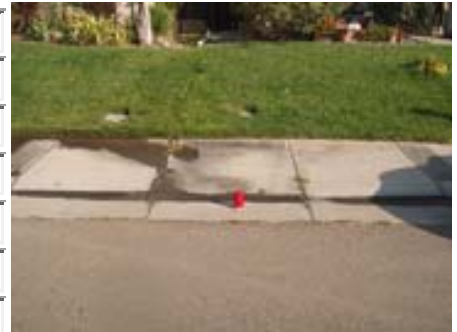
Barrier Type: Detectable Warnings - Truncated Domes

Code Ref: CBC 1127B.5.7 and ADA/ABA 705.1.3

As Built Meas: 1 Quantity: EACH

Description: No truncated domes provided at curb ramp

Bar. Severity: 2 Recommended Cost Estimate: \$1,400.00 Status:

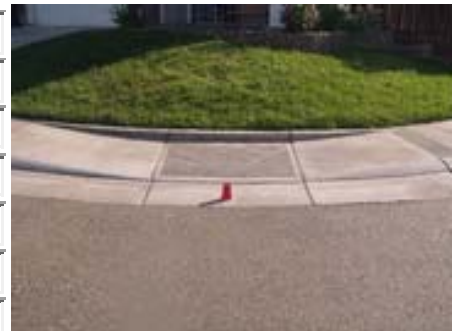
Barrier Type: Detectable Warnings - Truncated Domes

Code Ref: CBC 1127B.5.7 and ADA/ABA 705.1.3

As Built Meas: 1 Quantity: EACH

Description: No truncated domes provided at curb ramp

Bar. Severity: 2 Recommended Cost Estimate: \$1,400.00 Status:

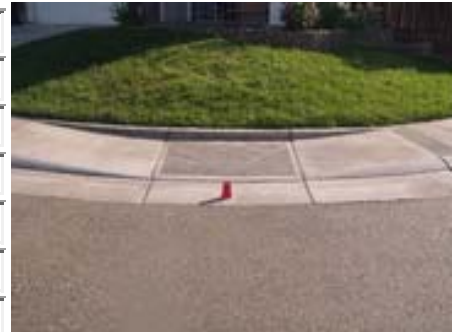
Barrier Type: Gutter Slope - Existing (6.6% to 8.2%)

Code Ref: CBC 1127B.5.3 and ADA/ABA 406.2

As Built Meas: 6 Quantity: SF

Description: Gutter slope exceeds 5.0% (6.6% to 8.2%)

Bar. Severity: 2 Recommended

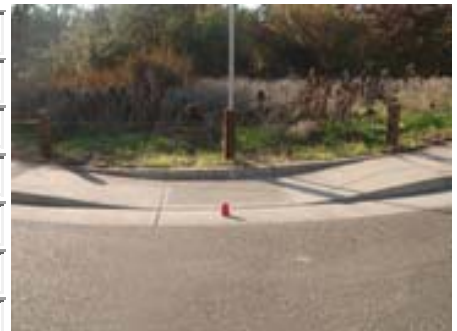
Barrier Type: Running Slope - Existing (9.5% or more)

Code Ref: CBC 1127B.5.3 and ADA/ABA 406.1

As Built Meas: 1 Quantity: EACH

Description: Ramp run cross slope exceeds 2.0% (9.5% or more)

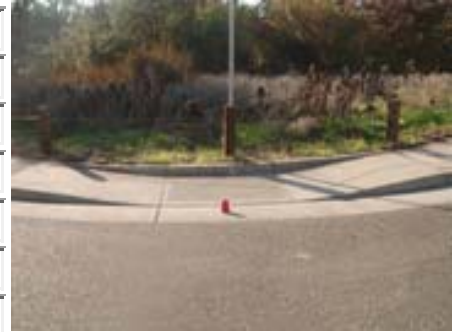
Barrier Type: Detectable Warnings - Truncated Domes

Code Ref: CBC 1127B.5.7 and ADA/ABA 705.1.3

As Built Meas: 1 Quantity: EACH

Description: No truncated domes provided at curb ramp

Bar. Severity: 2 Recommended Cost Estimate: \$0.00 Status:

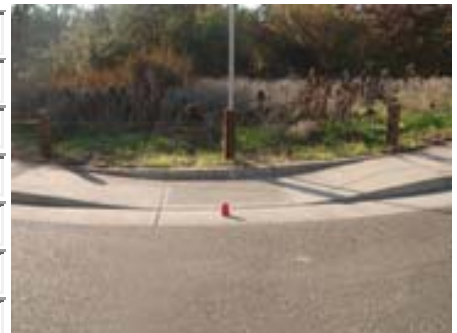
Barrier Type: Gutter Slope - Existing (6.6% to 8.2%)

Code Ref: CBC 1127B.5.3 and ADA/ABA 406.2

As Built Meas: 6 Quantity: SF

Description: Gutter slope exceeds 5.0% (6.6% to 8.2%)

Bar. Severity: 2 Recommended Cost Estimate: \$0.00 Status:

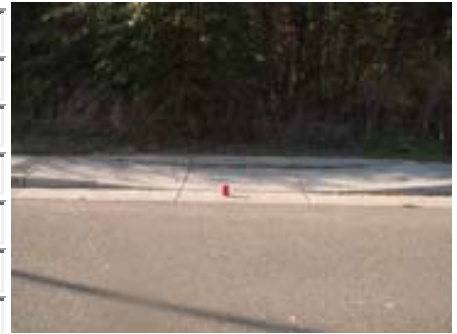
Barrier Type: Detectable Warnings - Truncated Domes

Code Ref: CBC 1127B.5.7 and ADA/ABA 705.1.3

As Built Meas: 1 Quantity: EACH

Description: No truncated domes provided at curb ramp

Bar. Severity: 2 Recommended Cost Estimate: \$1,400.00 Status:

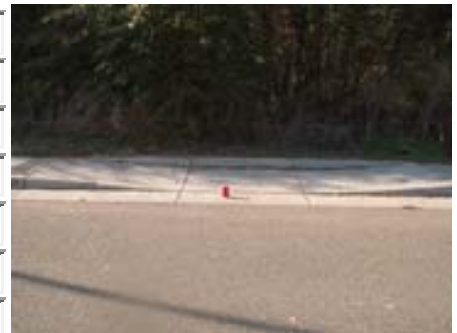
Barrier Type: Gutter Slope - Existing (8.3% or more)

Code Ref: CBC 1127B.5.3 and ADA/ABA 406.2

As Built Meas: 6 Quantity: SF

Description: Gutter slope exceeds 5.0% (8.3% or more)

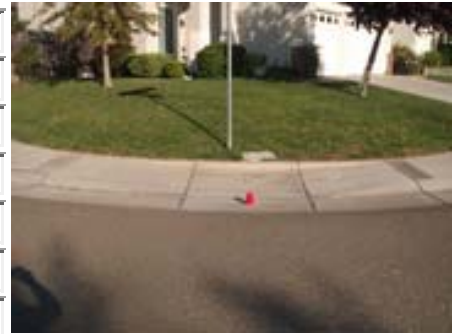
Field Date:	11/16/2010	Report Date:	11/16/2010	Barrier #:	2565A
Location:	Silver Saddle Wy and Trailride Wy - Corner C				
X Coordinate:	-121.31322				
Y Coordinate:	38.68904				
Barrier Area:	Curb Ramps				
Barrier Type:	12" Grooves - Existing (3.1% to 4.0%)				
Code Ref:	CBC 1127B.5.6

As Built Meas:	1	Quantity:	EACH	
Description:	12" grooves at top of curb ramp are not level (3.1% to 4.0%)			
As Built Desc:	3.8% in 12" grooves			
Solution:	Demolish existing and construct new curb ramp			
Bar. Severity:	3 Hindrance	Cost Estimate:	\$2,500.00	Status:
Implementation Priority:	4	Facility Function:		
Implementation Phase:		Implementation Date:		
Official Responsible:				
Notes:	Three - way intersection. Corners B,C,D

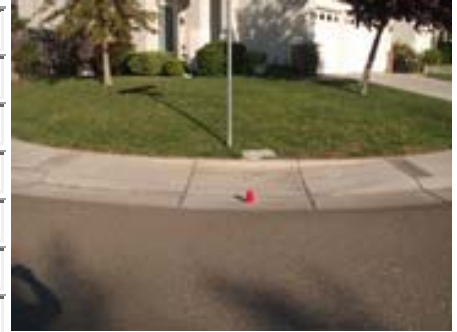
Barrier Type: Gutter Slope - Existing (6.6% to 8.2%)

Code Ref: CBC 1127B.5.3 and ADA/ABA 406.2

As Built Meas: 6 Quantity: SF

Description: Gutter slope exceeds 5.0% (6.6% to 8.2%)

Bar. Severity: 2 Recommended Cost Estimate: \$0.00 Status:

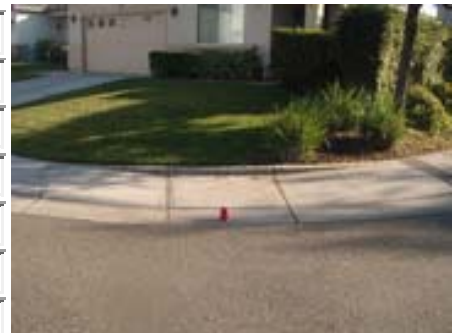
Barrier Type: Detectable Warnings - Truncated Domes

Code Ref: CBC 1127B.5.7 and ADA/ABA 705.1.3

As Built Meas: 1 Quantity: EACH

Description: No truncated domes provided at curb ramp

Bar. Severity: 2 Recommended Cost Estimate: \$1,400.00 Status:

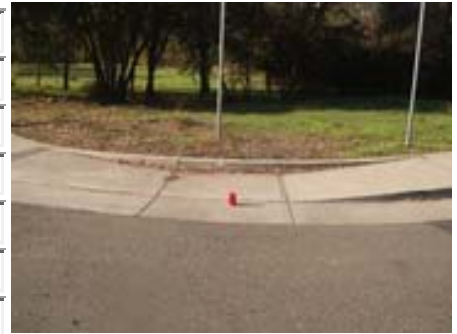
Barrier Type: Detectable Warnings - Truncated Domes

Code Ref: CBC 1127B.5.7 and ADA/ABA 705.1.3

As Built Meas: 1 Quantity: EACH

Description: No truncated domes provided at curb ramp

Bar. Severity: 2 Recommended Cost Estimate: \$1,400.00 Status:

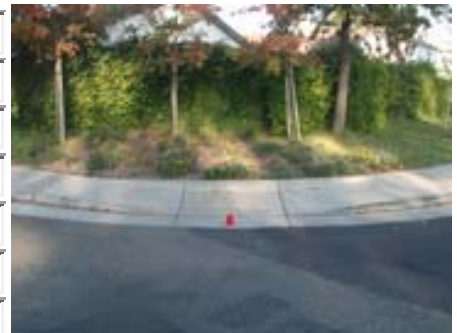
Barrier Type: Running Slope - Existing (9.5% or more)

Code Ref: CBC 1127B.5.3 and ADA/ABA 406.1

As Built Meas: 1 Quantity: EACH

Description: Ramp run cross slope exceeds 2.0% (9.5% or more)

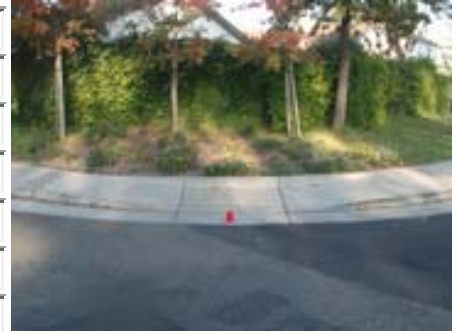
Barrier Type: 12" Grooves - Existing (3.1% to 4.0%)

Code Ref: CBC 1127B.5.6

As Built Meas: 1 Quantity: EACH

Description: 12" grooves at top of curb ramp are not level (3.1% to 4.0%)

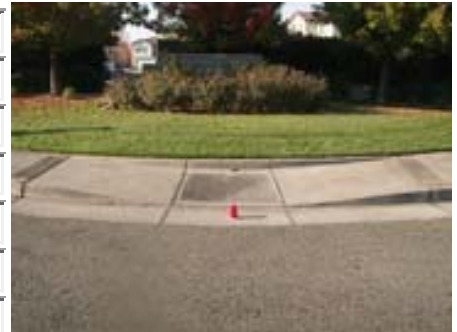
Barrier Type: Parallel Ramp Landing - Existing (3.1% to 4.0%)

Code Ref: CBC 1127B.5.4 and ADA/ABA 406.4

As Built Meas: 1 Quantity: EACH

Description: Curb ramp landing or pan not level (3.1% to 4.0%)

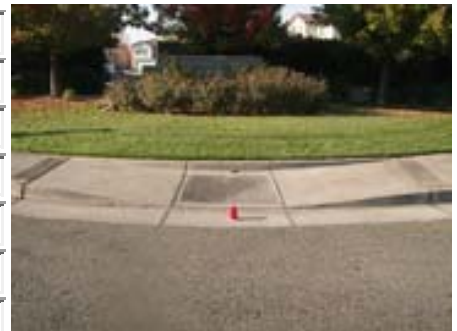
Barrier Type: Detectable Warnings - Truncated Domes

Code Ref: CBC 1127B.5.7 and ADA/ABA 705.1.3

As Built Meas: 1 Quantity: EACH

Description: No truncated domes provided at curb ramp

Bar. Severity: 2 Recommended

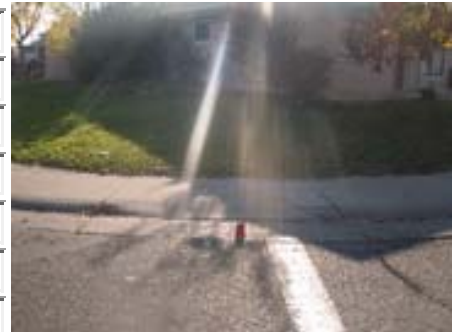
Barrier Type: No Curb Ramp - Depressed Existing Curb

Code Ref: CBC 1127B.5.1 and ADA/ABA 402.2

As Built Meas: 1 Quantity: EACH

Description: No compliant curb cut at corner (intersection)

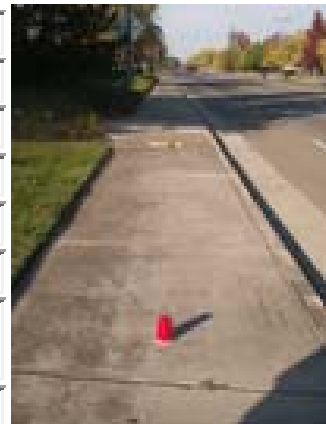
Barrier Type: Cross Slope - Existing (3.1% to 4.0%)

Code Ref: CBC 1133B.7.1.3 and ADA/ABA 403.3

As Built Meas: 30 Quantity: LF

Description: Cross slope exceeds 2.0% (3.1% to 4.0%)

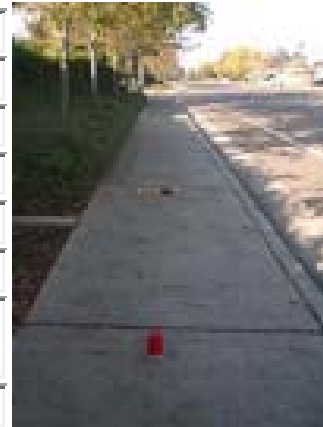
Barrier Type: Cross Slope - Existing (3.1% to 4.0%)

Code Ref: CBC 1133B.7.1.3 and ADA/ABA 403.3

As Built Meas: 105 Quantity: LF

Description: Cross slope exceeds 2.0% (3.1% to 4.0%)

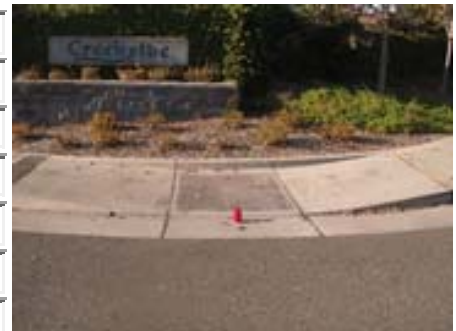
Barrier Type: 12" Grooves - Existing (4.1% to 4.9%)

Code Ref: CBC 1127B.5.6

As Built Meas: 1 Quantity: EACH

Description: 12" grooves at top of curb ramp are not level (4.1% to 4.9%)

Bar. Severity: 2 Recommended Cost Estimate: \$2,500.00 Status:

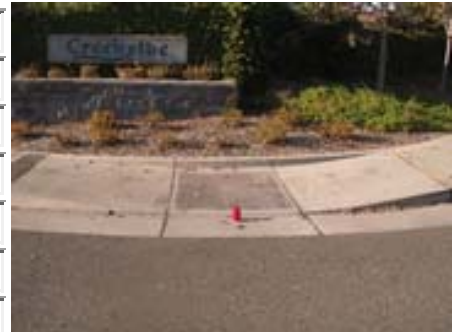
Barrier Type: Running Slope - Existing (9.5% or more)

Code Ref: CBC 1127B.5.3 and ADA/ABA 406.1

As Built Meas: 1 Quantity: EACH

Description: Ramp run cross slope exceeds 2.0% (9.5% or more)

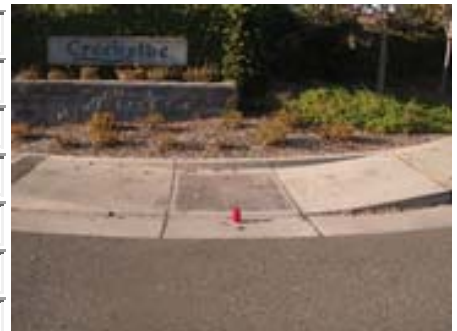
Barrier Type: Detectable Warnings - Truncated Domes

Code Ref: CBC 1127B.5.7 and ADA/ABA 705.1.3

As Built Meas: 1 Quantity: EACH

Description: No truncated domes provided at curb ramp

Bar. Severity: 2 Recommended Cost Estimate: \$0.00 Status:

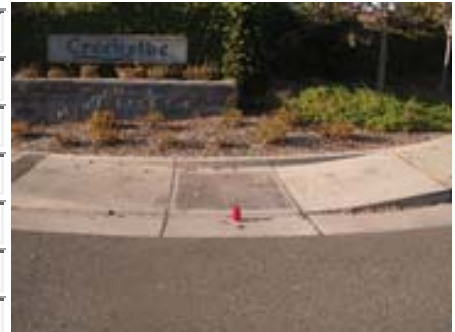
Barrier Type: Gutter Slope - Existing (6.6% to 8.2%)

Code Ref: CBC 1127B.5.3 and ADA/ABA 406.2

As Built Meas: 6 Quantity: SF

Description: Gutter slope exceeds 5.0% (6.6% to 8.2%)

Bar. Severity: 2 Recommended Cost Estimate: \$0.00 Status:
