SZS CONSULTING GROUP

DRAFT ADA TRANSITION PLAN UPDATE
NEIGHBORHOOD AREA 3 CHANT
SEPTEMBER 20, 2011

CITY OF CITRUS HEIGHTS

Citrus Heights Area Three (CHANT)

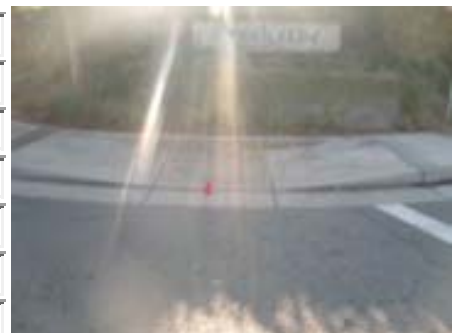
Barrier Type: Detectable Warnings - Truncated Domes

Code Ref: CBC 1127B.5.7 and ADA/ABA 705.1.3

As Built Meas: 1 Quantity: EACH

Description: No truncated domes provided at curb ramp

Bar. Severity: 2 Recommended Cost Estimate: \$1,400.00 Status:

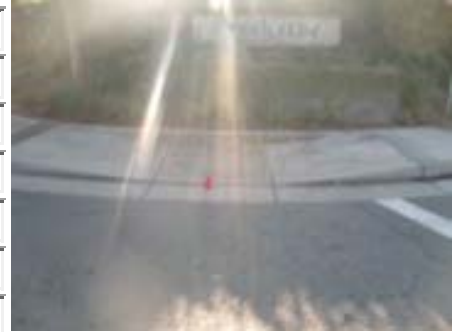
Barrier Type: Gutter Slope - Existing (5.9% - 6.5%)

Code Ref: CBC 1127B.5.3 and ADA/ABA 406.2

As Built Meas: 6 Quantity: SF

Description: Gutter slope exceeds 5.0% (5.9% - 6.5%)

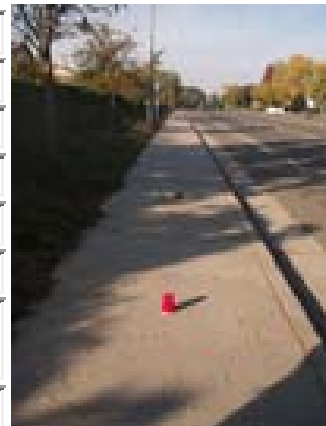
Barrier Type: Cross Slope - Existing (3.1% to 4.0%)

Code Ref: CBC 1133B.7.1.3 and ADA/ABA 403.3

As Built Meas: 531 Quantity: LF

Description: Cross slope exceeds 2.0% (3.1% to 4.0%)

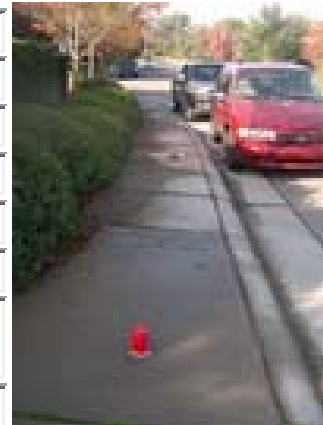
Barrier Type: Cross Slope - Existing (3.1% to 4.0%)

Code Ref: CBC 1133B.7.1.3 and ADA/ABA 403.3

As Built Meas: 65 Quantity: LF

Description: Cross slope exceeds 2.0% (3.1% to 4.0%)

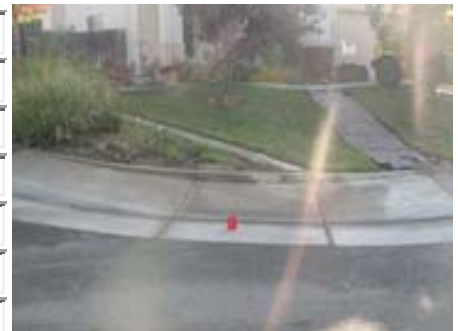
Barrier Type: 12" Grooves - Existing (>5.0%)

Code Ref: CBC 1127B.5.6

As Built Meas: 1 Quantity: EACH

Description: 12" grooves at top of curb ramp are not level (>5.0%)

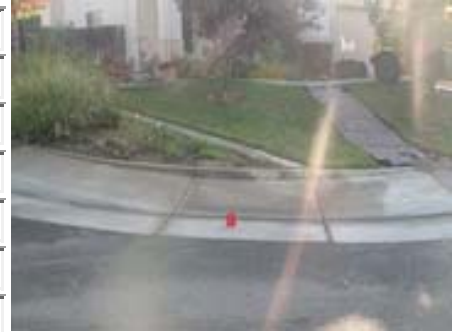
Barrier Type: Running Slope - Existing (9.0% to 9.4%)

Code Ref: CBC 1127B.5.3 and ADA/ABA 406.1

As Built Meas: 1 Quantity: EACH

Description: Ramp run cross slope exceeds 2.0% (9.0% to 9.4%)

Bar. Severity: 2 Recommended

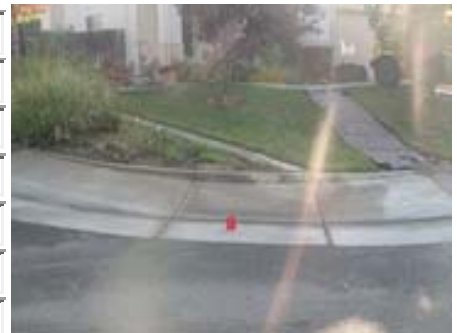
Barrier Type: Parallel Ramp Landing - Existing (3.1% to 4.0%)

Code Ref: CBC 1127B.5.4 and ADA/ABA 406.4

As Built Meas: 1 Quantity: EACH

Description: Curb ramp landing or pan not level (3.1% to 4.0%)

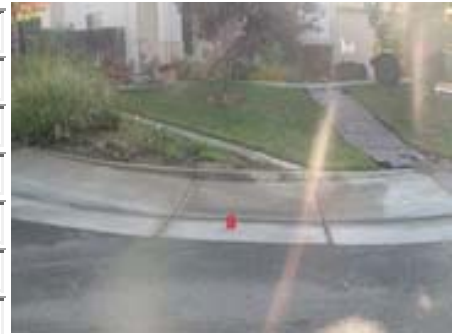
Barrier Type: Detectable Warnings - Truncated Domes

Code Ref: CBC 1127B.5.7 and ADA/ABA 705.1.3

As Built Meas: 1 Quantity: EACH

Description: No truncated domes provided at curb ramp

Bar. Severity: 2 Recommended Cost Estimate: \$0.00 Status:

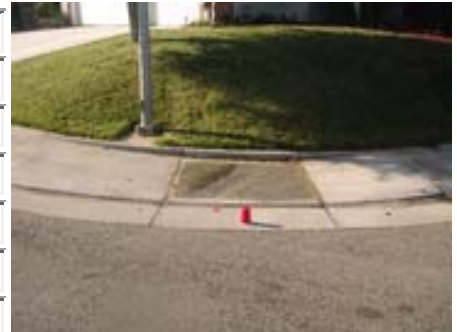
Barrier Type: 12" Grooves - Existing (>5.0%)

Code Ref: CBC 1127B.5.6

As Built Meas: 1 Quantity: EACH

Description: 12" grooves at top of curb ramp are not level (>5.0%)

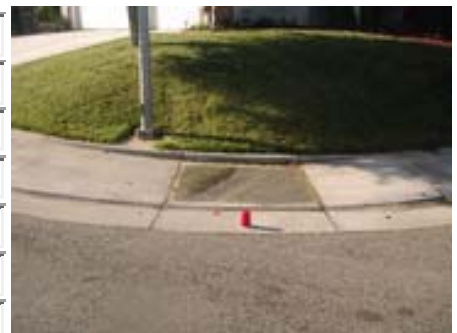
Barrier Type: Parallel Ramp Landing - Existing (3.1% to 4.0%)

Code Ref: CBC 1127B.5.4 and ADA/ABA 406.4

As Built Meas: 1 Quantity: EACH

Description: Curb ramp landing or pan not level (3.1% to 4.0%)

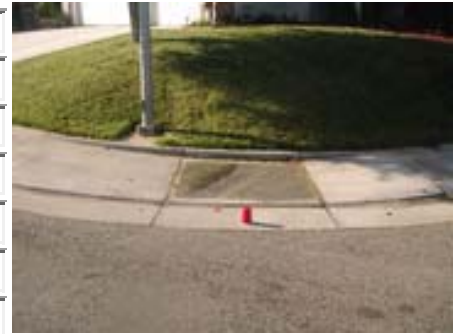
Barrier Type: Detectable Warnings - Truncated Domes

Code Ref: CBC 1127B.5.7 and ADA/ABA 705.1.3

As Built Meas: 1 Quantity: EACH

Description: No truncated domes provided at curb ramp

Bar. Severity: 2 Recommended

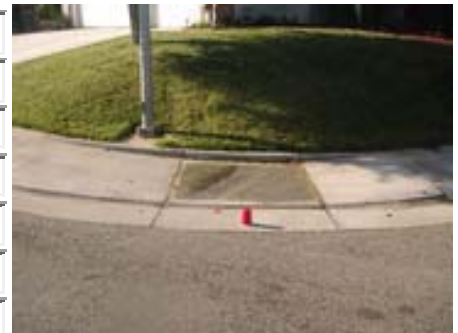
Barrier Type: Gutter Slope - Existing (8.3% or more)

Code Ref: CBC 1127B.5.3 and ADA/ABA 406.2

As Built Meas: 6 Quantity: SF

Description: Gutter slope exceeds 5.0% (8.3% or more)

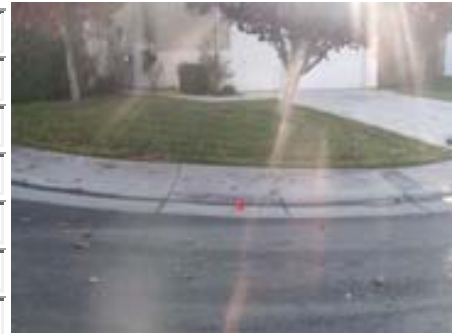
Barrier Type: 12" Grooves - Existing (4.1% to 4.9%)

Code Ref: CBC 1127B.5.6

As Built Meas: 1 Quantity: EACH

Description: 12" grooves at top of curb ramp are not level (4.1% to 4.9%)

Bar. Severity: 2 Recommended Cost Estimate: \$2,500.00 Status:

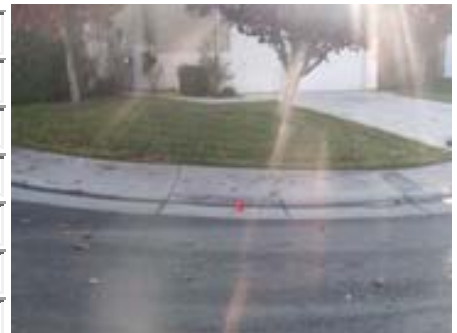
Barrier Type: Parallel Ramp Landing - Existing (3.1% to 4.0%)

Code Ref: CBC 1127B.5.4 and ADA/ABA 406.4

As Built Meas: 1 Quantity: EACH

Description: Curb ramp landing or pan not level (3.1% to 4.0%)

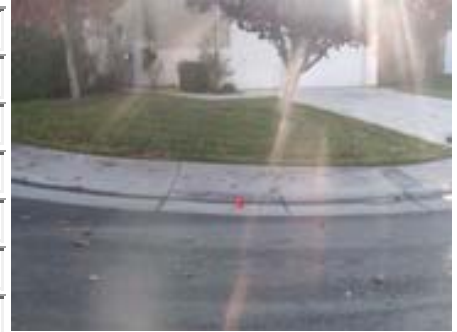
Barrier Type: Detectable Warnings - Truncated Domes

Code Ref: CBC 1127B.5.7 and ADA/ABA 705.1.3

As Built Meas: 1 Quantity: EACH

Description: No truncated domes provided at curb ramp

Bar. Severity: 2 Recommended Cost Estimate: \$0.00 Status:

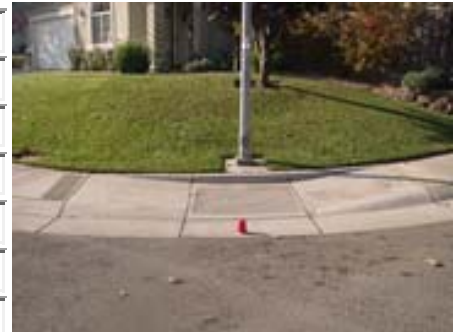
Barrier Type: Parallel Ramp Landing - Existing (3.1% to 4.0%)

Code Ref: CBC 1127B.5.4 and ADA/ABA 406.4

Description: Curb ramp landing or pan not level (3.1% to 4.0%)

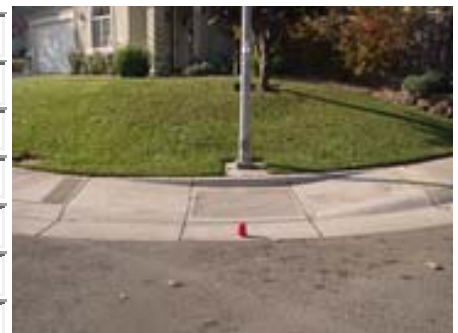
Barrier Type: Detectable Warnings - Truncated Domes

Code Ref: CBC 1127B.5.7 and ADA/ABA 705.1.3

Description: No truncated domes provided at curb ramp

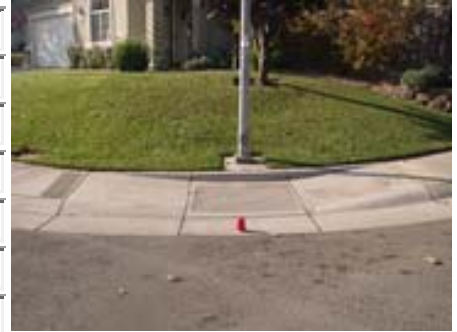
Barrier Type: Gutter Slope - Existing (6.6% to 8.2%)

Code Ref: CBC 1127B.5.3 and ADA/ABA 406.2

Description: Gutter slope exceeds 5.0% (6.6% to 8.2%)

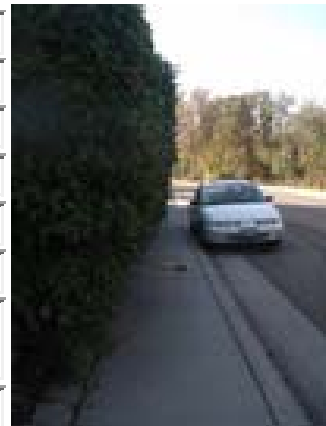
Barrier Type: Clear Width - Existing ($\leq 31"$ or less)

Code Ref: CBC 1133B.7.1

Description: Pedestrian route is not min. 48" wide ($\leq 31"$ or less)

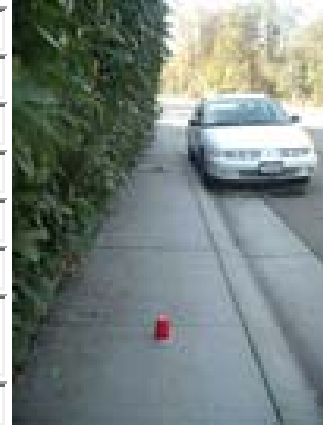
Barrier Type: Cross Slope - Existing (3.1% to 4.0%)

Code Ref: CBC 1133B.7.1.3 and ADA/ABA 403.3

Description: Cross slope exceeds 2.0% (3.1% to 4.0%)

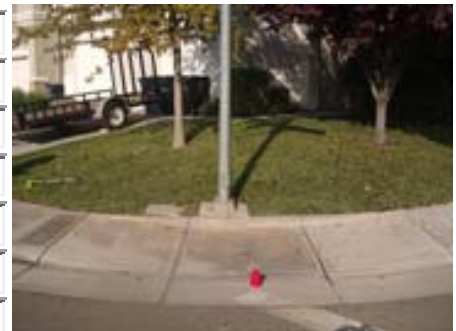
Barrier Type: Detectable Warnings - Truncated Domes

Code Ref: CBC 1127B.5.7 and ADA/ABA 705.1.3

Description: No truncated domes provided at curb ramp

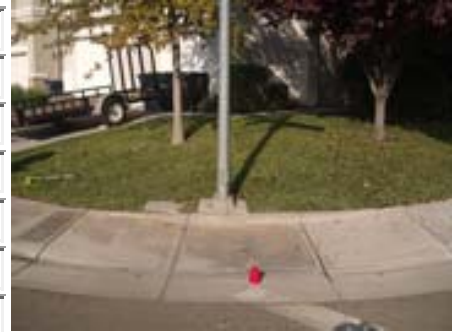
Barrier Type: Gutter Slope - Existing (6.6% to 8.2%)

Code Ref: CBC 1127B.5.3 and ADA/ABA 406.2

Description: Gutter slope exceeds 5.0% (6.6% to 8.2%)

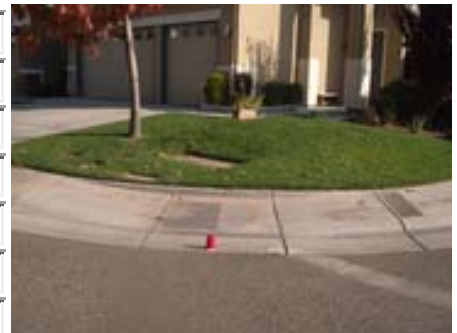
Barrier Type: Detectable Warnings - Truncated Domes

Code Ref: CBC 1127B.5.7 and ADA/ABA 705.1.3

Description: No truncated domes provided at curb ramp

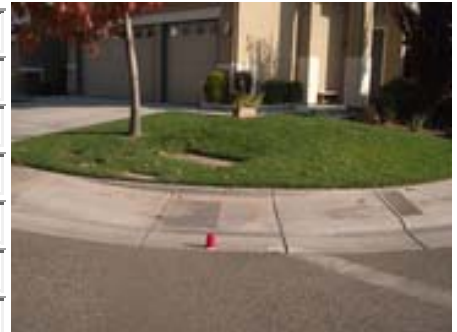
Barrier Type: Gutter Slope - Existing (8.3% or more)

Code Ref: CBC 1127B.5.3 and ADA/ABA 406.2

Description: Gutter slope exceeds 5.0% (8.3% or more)

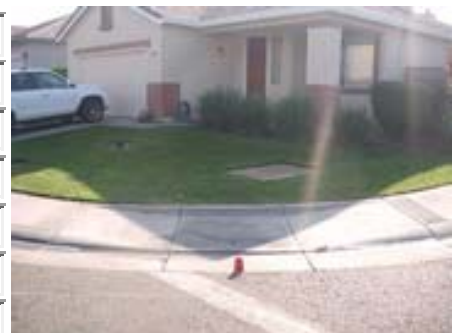
Barrier Type: Detectable Warnings - Truncated Domes

Code Ref: CBC 1127B.5.7 and ADA/ABA 705.1.3

Description: No truncated domes provided at curb ramp

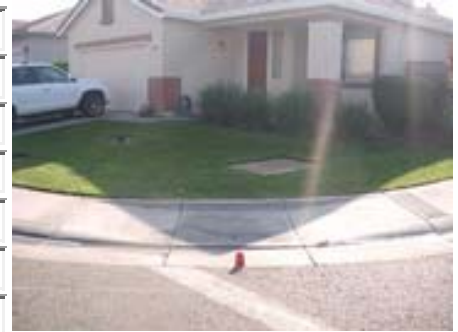
Barrier Type: Gutter Slope - Existing (5.1% - 5.8%)

Code Ref: CBC 1127B.5.3 and ADA/ABA 406.2

Description: Gutter slope exceeds 5.0% (5.1% - 5.8%)

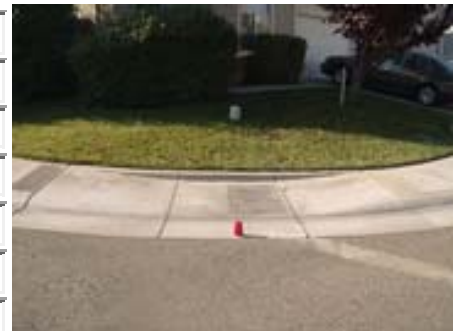
Barrier Type: Detectable Warnings - Truncated Domes

Code Ref: CBC 1127B.5.7 and ADA/ABA 705.1.3

Description: No truncated domes provided at curb ramp

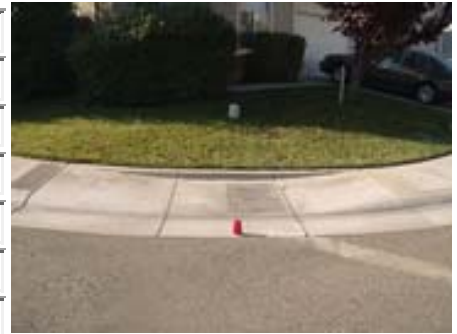
Barrier Type: Gutter Slope - Existing (6.6% to 8.2%)

Code Ref: CBC 1127B.5.3 and ADA/ABA 406.2

Description: Gutter slope exceeds 5.0% (6.6% to 8.2%)

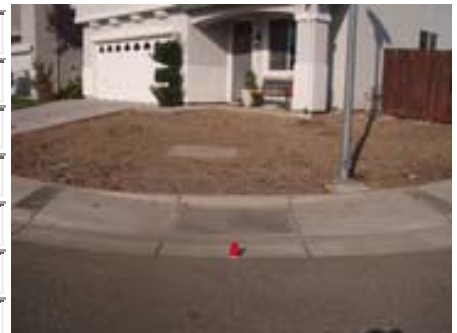
Barrier Type: Detectable Warnings - Truncated Domes

Code Ref: CBC 1127B.5.7 and ADA/ABA 705.1.3

Description: No truncated domes provided at curb ramp

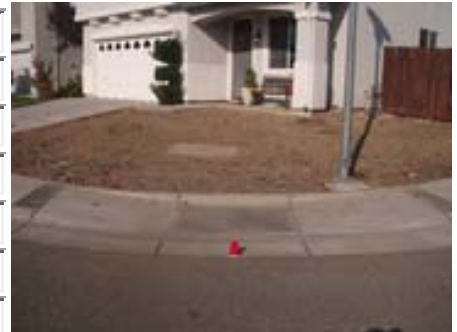
Barrier Type: Gutter Slope - Existing (6.6% to 8.2%)

Code Ref: CBC 1127B.5.3 and ADA/ABA 406.2

Description: Gutter slope exceeds 5.0% (6.6% to 8.2%)

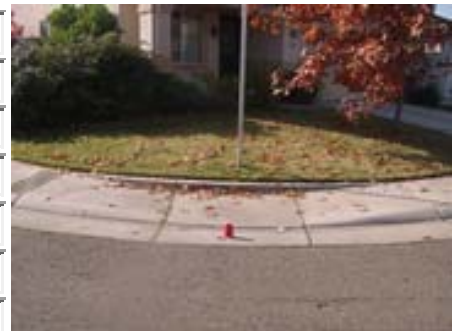
Barrier Type: Detectable Warnings - Truncated Domes

Code Ref: CBC 1127B.5.7 and ADA/ABA 705.1.3

Description: No truncated domes provided at curb ramp

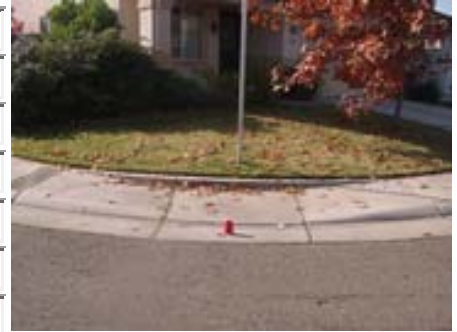
Barrier Type: Gutter Slope - Existing (6.6% to 8.2%)

Code Ref: CBC 1127B.5.3 and ADA/ABA 406.2

Description: Gutter slope exceeds 5.0% (6.6% to 8.2%)

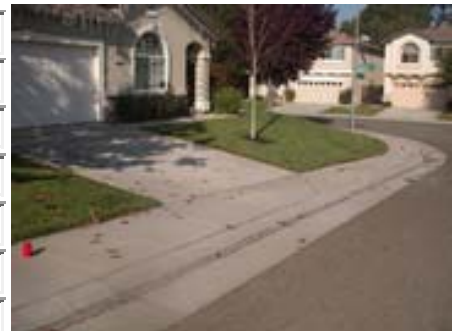
Barrier Type: Running Slope (Existing)

Code Ref: CBC 1133B.7.3 and ADA/ABA 403.3

Description: Running slope exceeds 5.0%

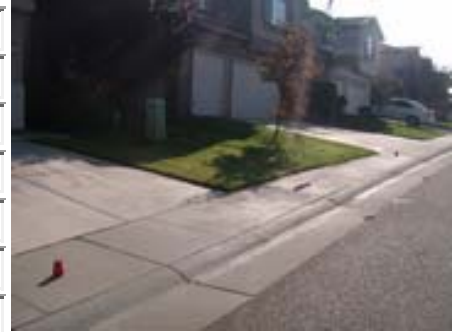
Barrier Type: Running Slope (Existing)

Code Ref: CBC 1133B.7.3 and ADA/ABA 403.3

Description: Running slope exceeds 5.0%

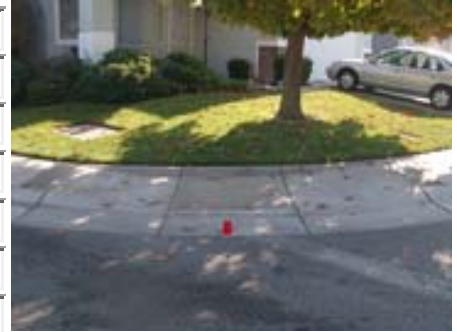
Barrier Type: Parallel Ramp Landing - Existing (4.1% to 4.9%)

Code Ref: CBC 1127B.5.4 and ADA/ABA 406.4

Description: Curb ramp landing or pan not level(4.1% to 4.9%)

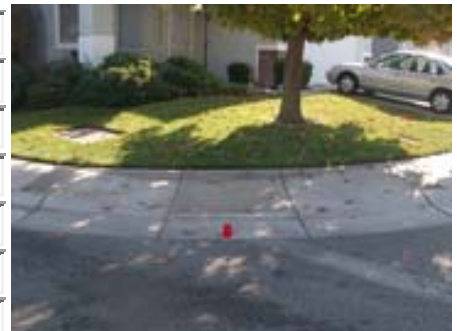
Barrier Type: Detectable Warnings - Truncated Domes

Code Ref: CBC 1127B.5.7 and ADA/ABA 705.1.3

Description: No truncated domes provided at curb ramp

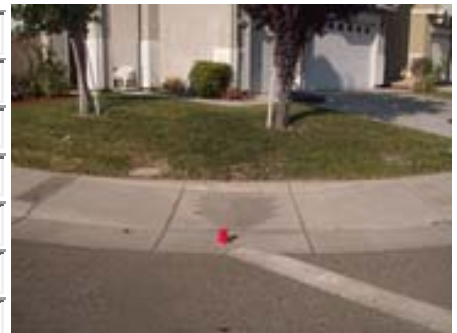
Barrier Type: Detectable Warnings - Truncated Domes

Code Ref: CBC 1127B.5.7 and ADA/ABA 705.1.3

Description: No truncated domes provided at curb ramp

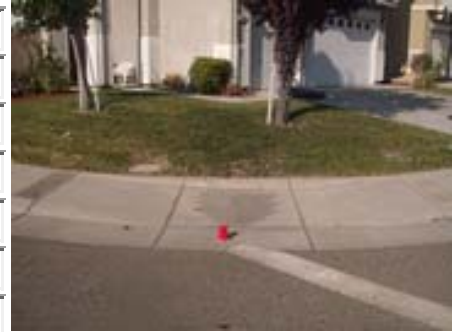
Barrier Type: Gutter Slope - Existing (5.9% - 6.5%)

Code Ref: CBC 1127B.5.3 and ADA/ABA 406.2

Description: Gutter slope exceeds 5.0% (5.9% - 6.5%)

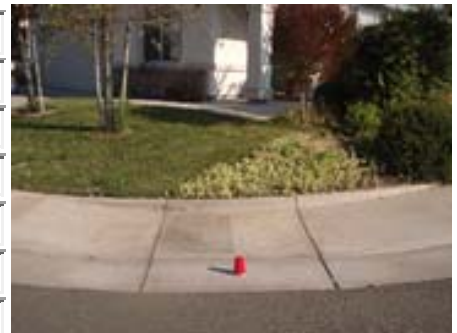
Barrier Type: Parallel Ramp Landing - Existing (3.1% to 4.0%)

Code Ref: CBC 1127B.5.4 and ADA/ABA 406.4

Description: Curb ramp landing or pan not level (3.1% to 4.0%)

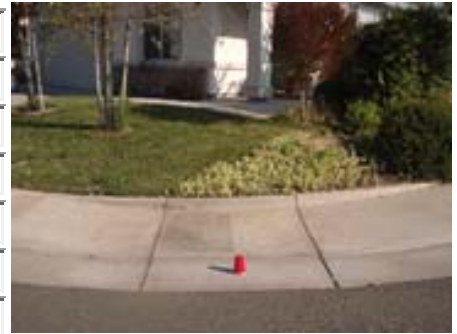
Barrier Type: Detectable Warnings - Truncated Domes

Code Ref: CBC 1127B.5.7 and ADA/ABA 705.1.3

Description: No truncated domes provided at curb ramp

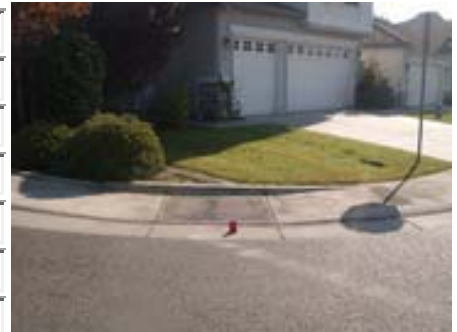
Barrier Type: 12" Grooves - Existing (4.1% to 4.9%)

Code Ref: CBC 1127B.5.6

Description: 12" grooves at top of curb ramp are not level (4.1% to 4.9%)

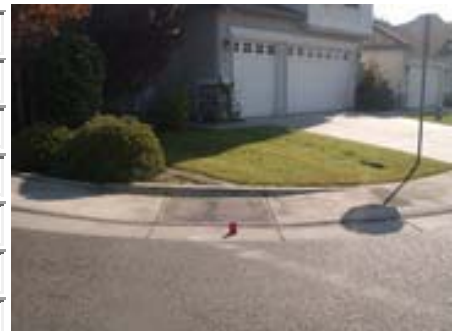
Barrier Type: Parallel Ramp Landing - Existing (3.1% to 4.0%)

Code Ref: CBC 1127B.5.4 and ADA/ABA 406.4

Description: Curb ramp landing or pan not level (3.1% to 4.0%)

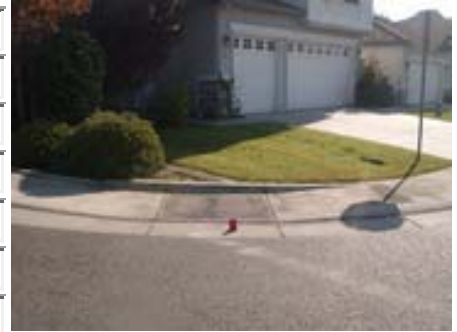
Barrier Type: Detectable Warnings - Truncated Domes

Code Ref: CBC 1127B.5.7 and ADA/ABA 705.1.3

Description: No truncated domes provided at curb ramp

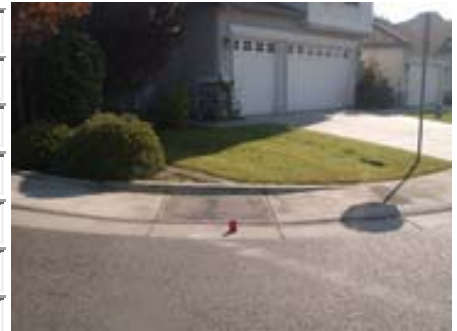
Barrier Type: Gutter Slope - Existing (6.6% to 8.2%)

Code Ref: CBC 1127B.5.3 and ADA/ABA 406.2

Description: Gutter slope exceeds 5.0% (6.6% to 8.2%)

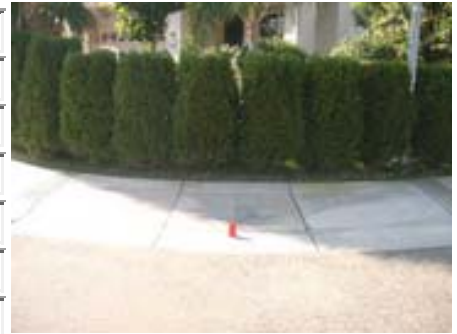
Barrier Type: Detectable Warnings - Truncated Domes

Code Ref: CBC 1127B.5.7 and ADA/ABA 705.1.3

Description: No truncated domes provided at curb ramp

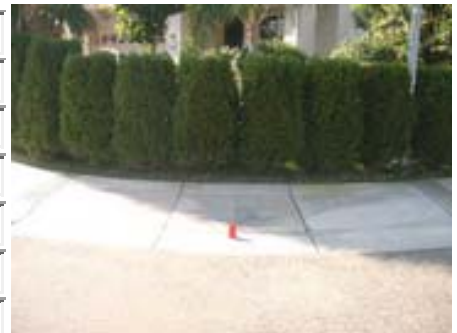
Barrier Type: Gutter Slope - Existing (5.1% - 5.8%)

Code Ref: CBC 1127B.5.3 and ADA/ABA 406.2

Description: Gutter slope exceeds 5.0% (5.1% - 5.8%)

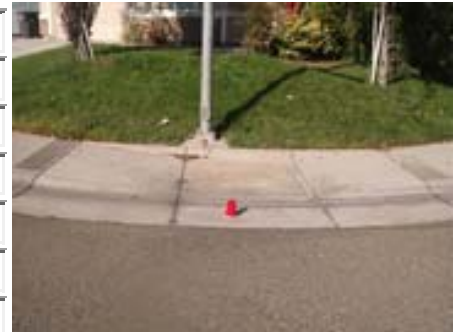
Barrier Type: Detectable Warnings - Truncated Domes

Code Ref: CBC 1127B.5.7 and ADA/ABA 705.1.3

Description: No truncated domes provided at curb ramp

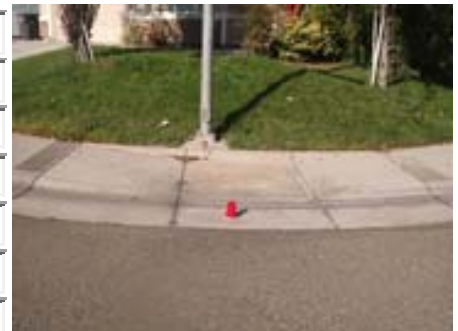
Barrier Type: Gutter Slope - Existing (5.9% - 6.5%)

Code Ref: CBC 1127B.5.3 and ADA/ABA 406.2

Description: Gutter slope exceeds 5.0% (5.9% - 6.5%)

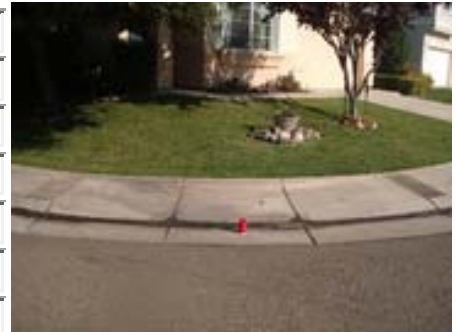
Barrier Type: Detectable Warnings - Truncated Domes

Code Ref: CBC 1127B.5.7 and ADA/ABA 705.1.3

Description: No truncated domes provided at curb ramp

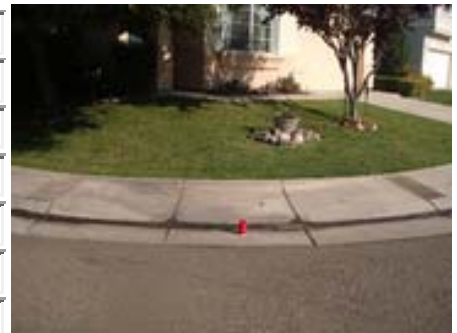
Barrier Type: Gutter Slope - Existing (5.9% - 6.5%)

Code Ref: CBC 1127B.5.3 and ADA/ABA 406.2

Description: Gutter slope exceeds 5.0% (5.9% - 6.5%)

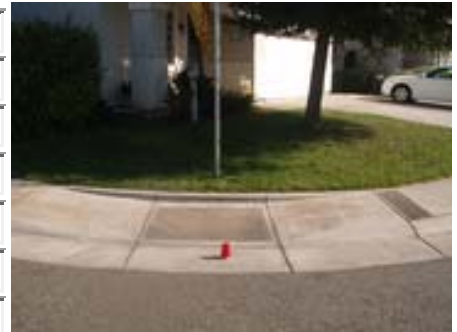
Barrier Type: Detectable Warnings - Truncated Domes

Code Ref: CBC 1127B.5.7 and ADA/ABA 705.1.3

Description: No truncated domes provided at curb ramp

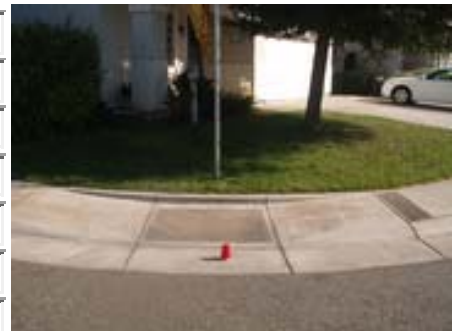
Barrier Type: Gutter Slope - Existing (5.9% - 6.5%)

Code Ref: CBC 1127B.5.3 and ADA/ABA 406.2

Description: Gutter slope exceeds 5.0% (5.9% - 6.5%)

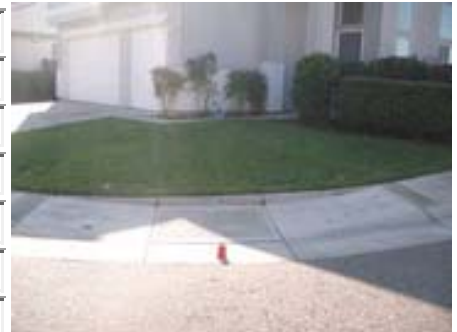
Barrier Type: 12" Grooves - Existing (3.1% to 4.0%)

Code Ref: CBC 1127B.5.6

Description: 12" grooves at top of curb ramp are not level (3.1% to 4.0%)

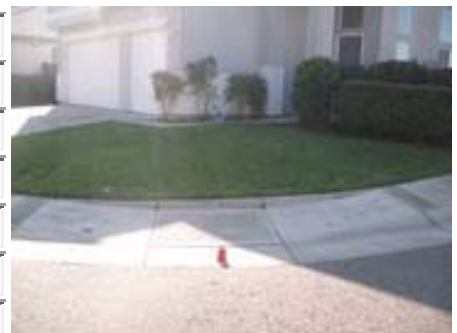
Barrier Type: Parallel Ramp Landing - Existing (3.1% to 4.0%)

Code Ref: CBC 1127B.5.4 and ADA/ABA 406.4

Description: Curb ramp landing or pan not level (3.1% to 4.0%)

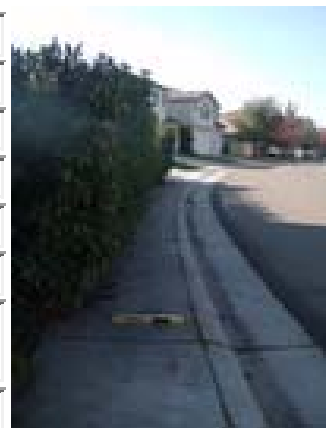
Barrier Type: Clear Width - Existing (32" to 35")

Code Ref: CBC 1133B.7.1

Description: Pedestrian route is not min. 48" wide (32" to 35")

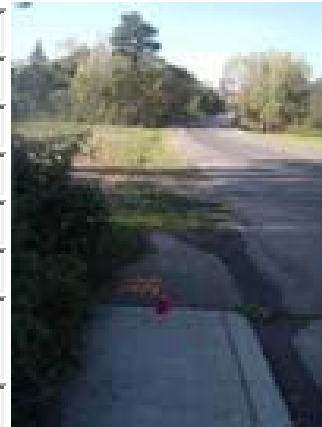
Barrier Type: No Sidewalk - No Barricade

Code Ref: MUTCD Section 6D.01

Description: No barricade provided where sidewalk ends in hazardous location

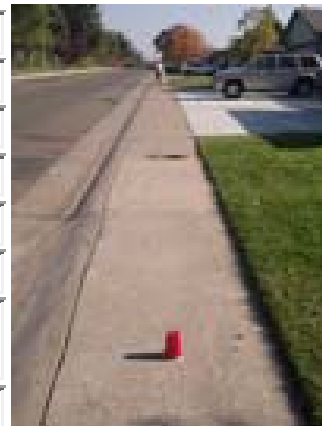
Barrier Type: Cross Slope - Existing (5.0% or more)

Code Ref: CBC 1133B.7.1.3 and ADA/ABA 403.3

Description: Cross slope exceeds 2.0% (5.0% or more)

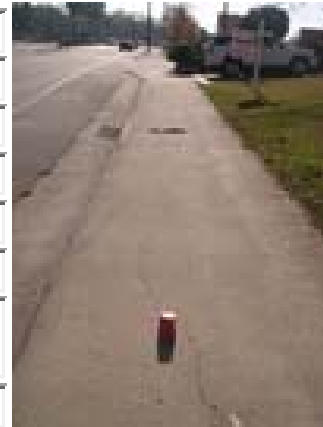
Barrier Type: Cross Slope - Existing (3.1% to 4.0%)

Code Ref: CBC 1133B.7.1.3 and ADA/ABA 403.3

Description: Cross slope exceeds 2.0% (3.1% to 4.0%)

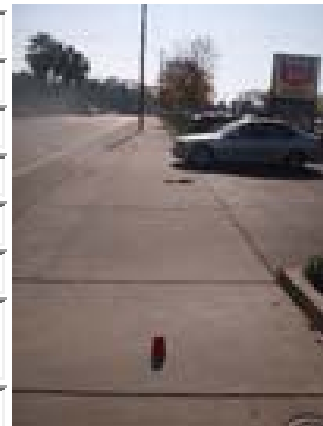
Barrier Type: Driveway - Existing (5.0% or more)

Code Ref: CBC 1133B.7.1.3 and ADA/ABA 403.3

Description: Driveway cross slope exceeds 2.0% (5.0% or more)

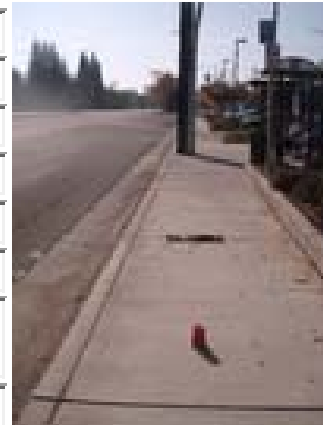
Barrier Type: Cross Slope - Existing (4.1% to 4.9%)

Code Ref: CBC 1133B.7.1.3 and ADA/ABA 403.3

Description: Cross slope exceeds 2.0% (4.1% to 4.9%)

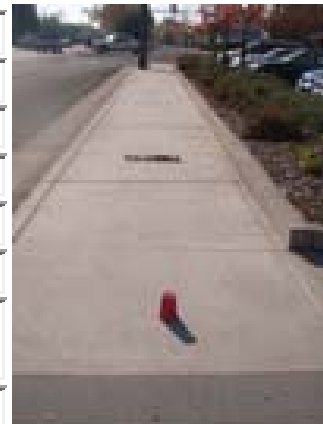
Barrier Type: Cross Slope - Existing (4.1% to 4.9%)

Code Ref: CBC 1133B.7.1.3 and ADA/ABA 403.3

Description: Cross slope exceeds 2.0% (4.1% to 4.9%)

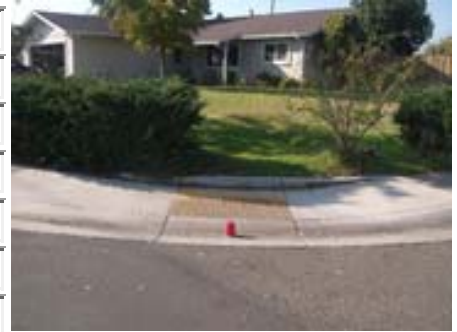
Barrier Type: 12" Grooves - Existing (>5.0%)

Code Ref: CBC 1127B.5.6

Description: 12" grooves at top of curb ramp are not level (>5.0%)

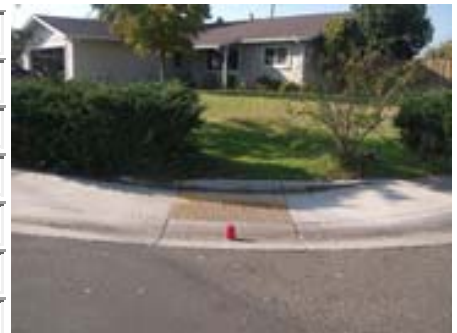
Barrier Type: Gutter Slope - Existing (8.3% or more)

Code Ref: CBC 1127B.5.3 and ADA/ABA 406.2

Description: Gutter slope exceeds 5.0% (8.3% or more)

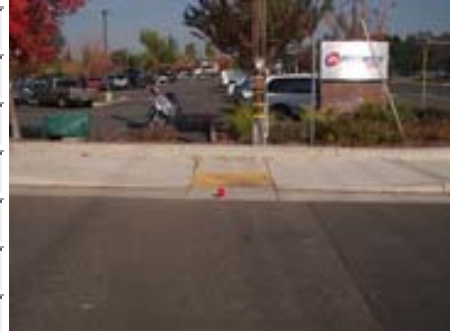
Barrier Type: 12" Grooves - Existing (>5.0%)

Code Ref: CBC 1127B.5.6

Description: 12" grooves at top of curb ramp are not level (>5.0%)

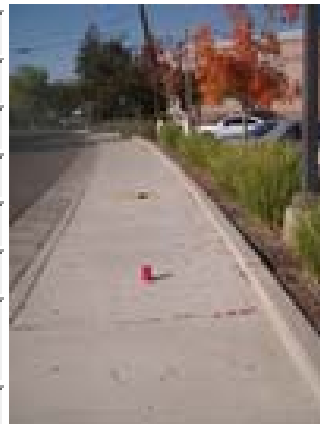
Barrier Type: Cross Slope - Existing (3.1% to 4.0%)

Code Ref: CBC 1133B.7.1.3 and ADA/ABA 403.3

Description: Cross slope exceeds 2.0% (3.1% to 4.0%)

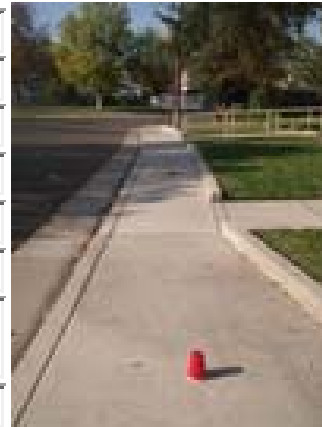
Barrier Type: Cross Slope - Existing (5.0% or more)

Code Ref: CBC 1133B.7.1.3 and ADA/ABA 403.3

Description: Cross slope exceeds 2.0% (5.0% or more)

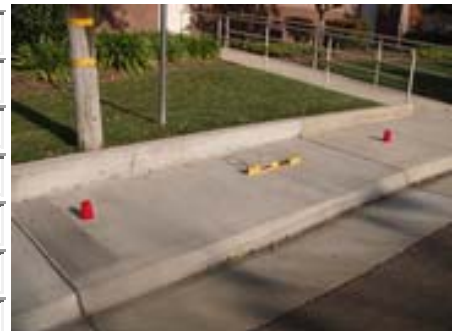
Barrier Type: Running Slope (Existing)

Code Ref: CBC 1133B.7.3 and ADA/ABA 403.3

Description: Running slope exceeds 5.0%

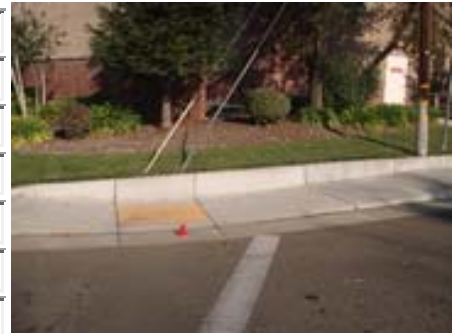
Barrier Type: 12" Grooves - Existing (>5.0%)

Code Ref: CBC 1127B.5.6

Description: 12" grooves at top of curb ramp are not level (>5.0%)

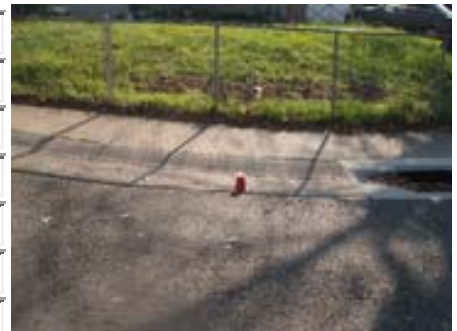
Barrier Type: No Curb Ramp

Code Ref: CBC 1127B.5.1 and ADA/ABA 402.2

Description: No curb cut at corner (intersection)

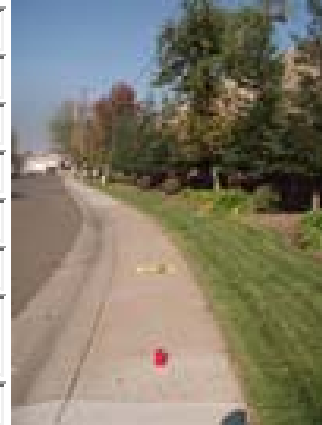
Barrier Type: Cross Slope - Existing (5.0% or more)

Code Ref: CBC 1133B.7.1.3 and ADA/ABA 403.3

Description: Cross slope exceeds 2.0% (5.0% or more)

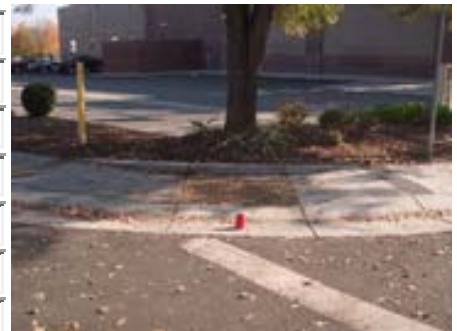
Barrier Type: 12" Grooves - Existing (4.1% to 4.9%)

Code Ref: CBC 1127B.5.6

Description: 12" grooves at top of curb ramp are not level (4.1% to 4.9%)

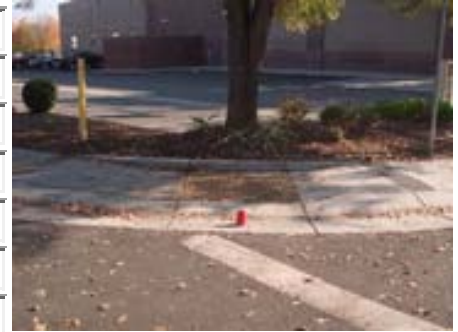
Barrier Type: Gutter Slope - Existing (8.3% or more)

Code Ref: CBC 1127B.5.3 and ADA/ABA 406.2

Description: Gutter slope exceeds 5.0% (8.3% or more)

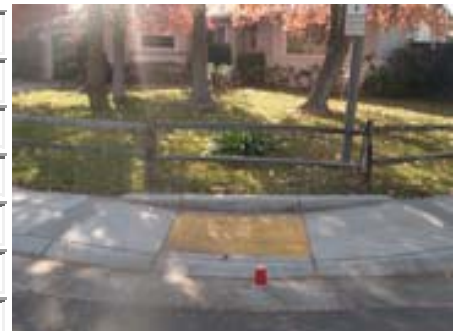
Barrier Type: 12" Grooves - New Construction

Code Ref: CBC 1127B.5.6

Description: 12" grooves at top of curb ramp are not level (3.1% to 4.0%)

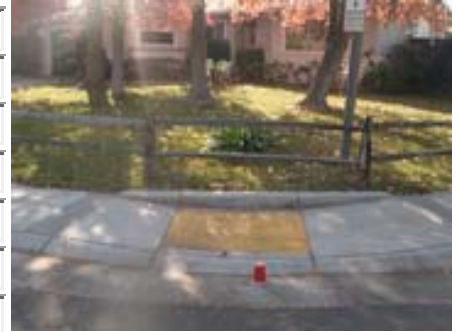
Barrier Type: Gutter Slope - New Construction

Code Ref: CBC 1127B.5.3 and ADA/ABA 406.2

Description: Gutter slope exceeds 5.0% (5.9% - 6.5%)

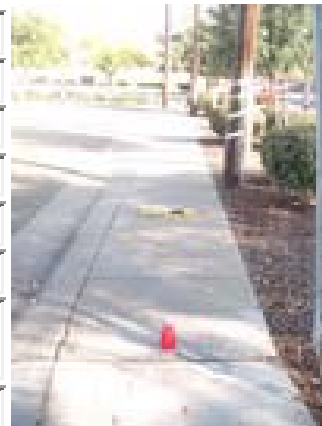
Barrier Type: Cross Slope - Existing (5.0% or more)

Code Ref: CBC 1133B.7.1.3 and ADA/ABA 403.3

Description: Cross slope exceeds 2.0% (5.0% or more)

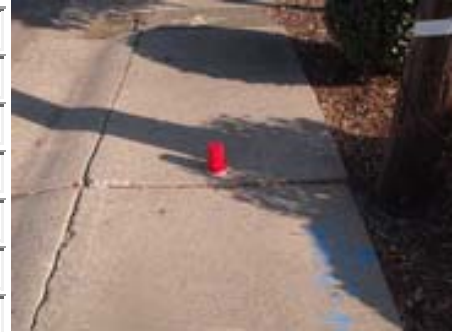
Barrier Type: Abrupt Change in Level - > 1/2"

Code Ref: CBC 1133B.7.1 and ADA/ABA 303.3

Description: Change in level greater than 1/2"

Solution: Grind or repair sidewalk to remove trip hazard

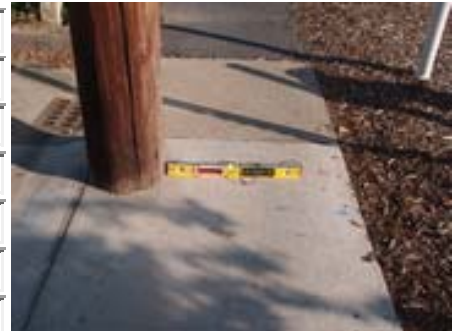
Barrier Type: Clear Width - Existing ($\leq 31"$ or less)

Code Ref: CBC 1133B.7.1

Description: Pedestrian route is not min. 48" wide ($\leq 31"$ or less)

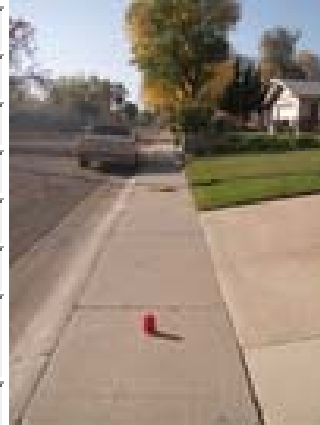
Barrier Type: Cross Slope - Existing (5.0% or more)

Code Ref: CBC 1133B.7.1.3 and ADA/ABA 403.3

Description: Cross slope exceeds 2.0% (5.0% or more)

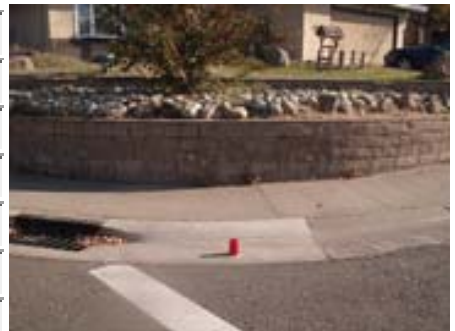
Barrier Type: No Curb Ramp

Code Ref: CBC 1127B.5.1 and ADA/ABA 402.2

Description: No curb cut at corner (intersection)

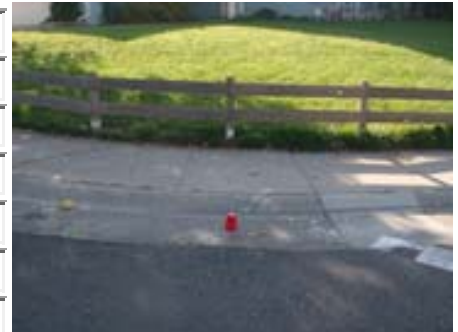
Barrier Type: No Curb Ramp

Code Ref: CBC 1127B.5.1 and ADA/ABA 402.2

Description: No curb cut at corner (intersection)

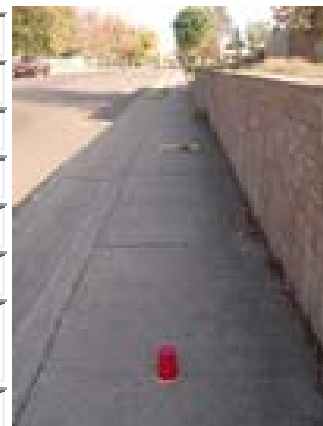
Barrier Type: Cross Slope - Existing (5.0% or more)

Code Ref: CBC 1133B.7.1.3 and ADA/ABA 403.3

Description: Cross slope exceeds 2.0% (5.0% or more)

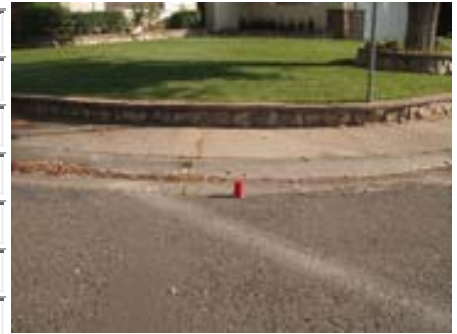
Barrier Type: No Curb Ramp

Code Ref: CBC 1127B.5.1 and ADA/ABA 402.2

Description: No curb cut at corner (intersection)

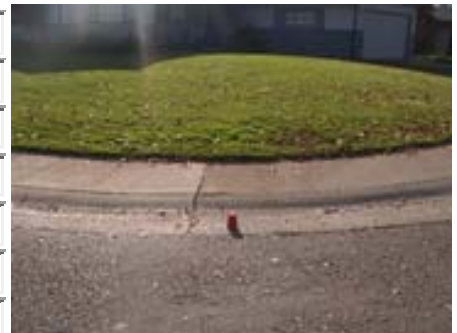
Barrier Type: No Curb Ramp

Code Ref: CBC 1127B.5.1 and ADA/ABA 402.2

Description: No curb cut at corner (intersection)

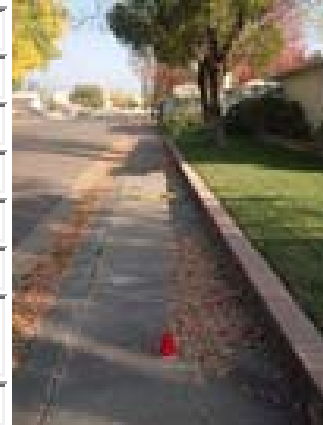
Barrier Type: Cross Slope - Existing (5.0% or more)

Code Ref: CBC 1133B.7.1.3 and ADA/ABA 403.3

Description: Cross slope exceeds 2.0% (5.0% or more)

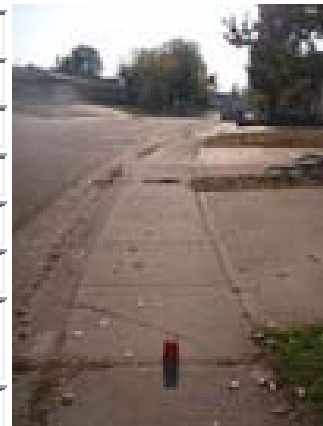
Barrier Type: Cross Slope - Existing (5.0% or more)

Code Ref: CBC 1133B.7.1.3 and ADA/ABA 403.3

Description: Cross slope exceeds 2.0% (5.0% or more)

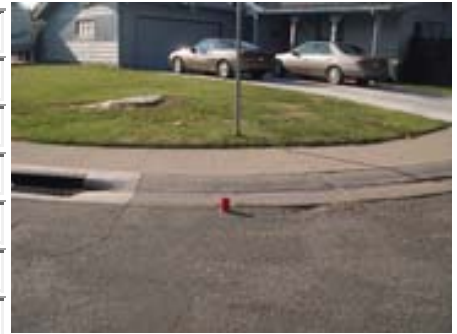
Barrier Type: No Curb Ramp

Code Ref: CBC 1127B.5.1 and ADA/ABA 402.2

Description: No curb cut at corner (intersection)

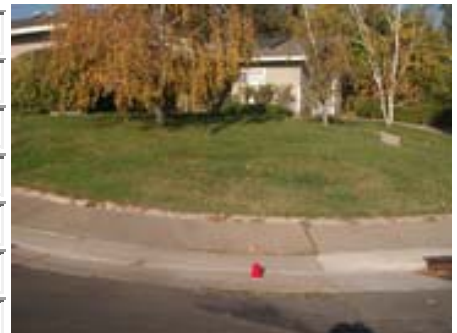
Barrier Type: No Curb Ramp

Code Ref: CBC 1127B.5.1 and ADA/ABA 402.2

Description: No curb cut at corner (intersection)

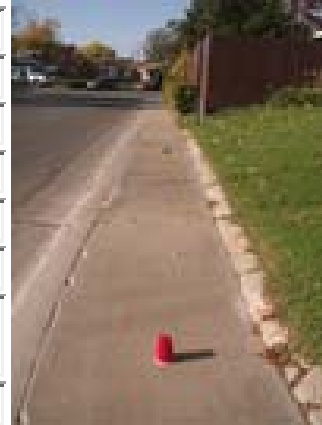
Barrier Type: Cross Slope - Existing (5.0% or more)

Code Ref: CBC 1133B.7.1.3 and ADA/ABA 403.3

Description: Cross slope exceeds 2.0% (5.0% or more)

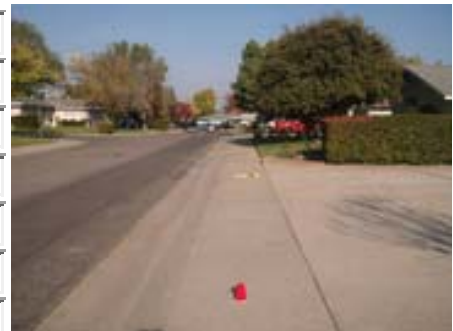
Barrier Type: Cross Slope - Existing (4.1% to 4.9%)

Code Ref: CBC 1133B.7.1.3 and ADA/ABA 403.3

Description: Cross slope exceeds 2.0% (4.1% to 4.9%)

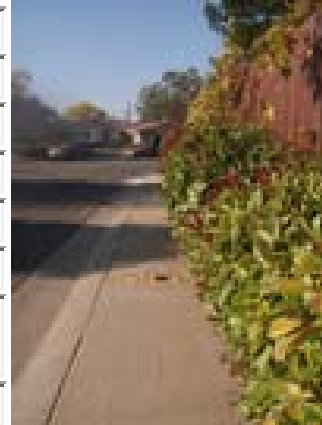
Barrier Type: Clear Width - Existing ($\leq 31"$ or less)

Code Ref: CBC 1133B.7.1

Description: Pedestrian route is not min. 48" wide ($\leq 31"$ or less)

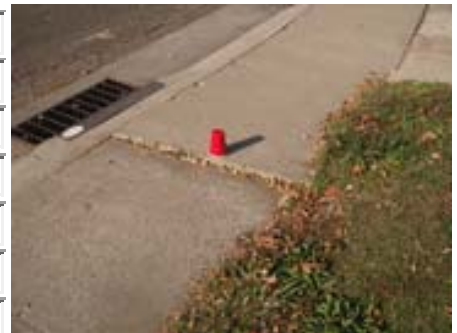
Barrier Type: Abrupt Change in Level - $> 1/2"$

Code Ref: CBC 1133B.7.1 and ADA/ABA 303.3

Description: Change in level greater than $1/2"$

Solution: Grind or repair sidewalk to remove trip hazard

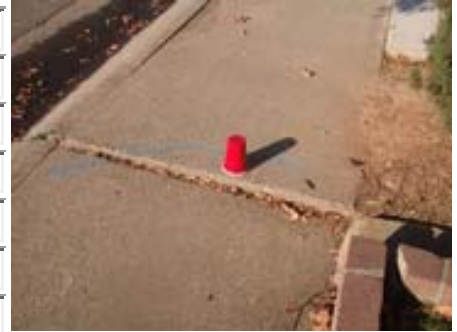
Barrier Type: Abrupt Change in Level - > 1/2"

Code Ref: CBC 1133B.7.1 and ADA/ABA 303.3

Description: Change in level greater than 1/2"

Solution: Grind or repair sidewalk to remove trip hazard

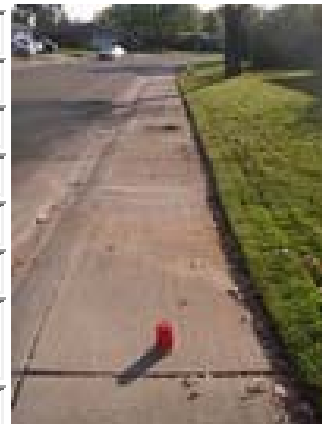
Barrier Type: Cross Slope - Existing (5.0% or more)

Code Ref: CBC 1133B.7.1.3 and ADA/ABA 403.3

Description: Cross slope exceeds 2.0% (5.0% or more)

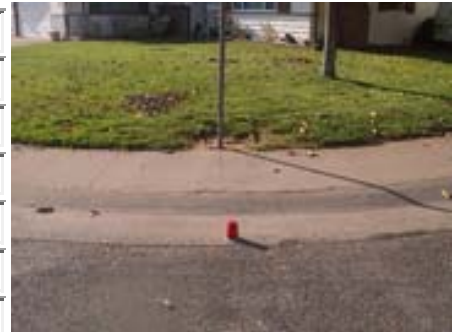
Barrier Type: No Curb Ramp

Description: No curb cut at corner (intersection)

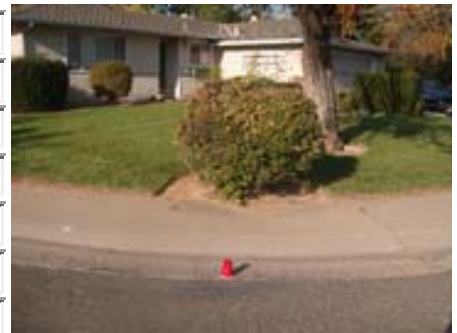
Barrier Type: No Curb Ramp

Description: No curb cut at corner (intersection)

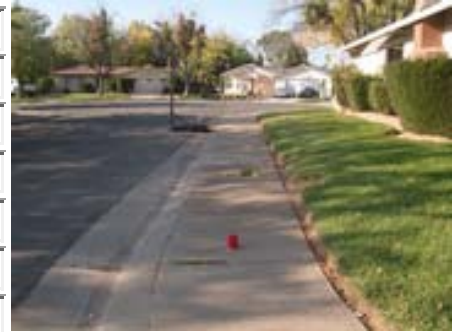
Barrier Type: Cross Slope - Existing (4.1% to 4.9%)

Description: Cross slope exceeds 2.0% (4.1% to 4.9%)

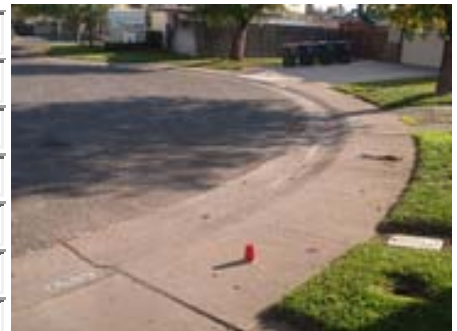
Barrier Type: Cross Slope - Existing (5.0% or more)

Description: Cross slope exceeds 2.0% (5.0% or more)

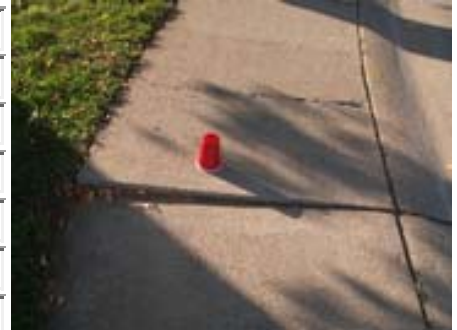
Barrier Type: Abrupt Change in Level - > 1/2"

Description: Change in level greater than 1/2"

Solution: Grind or repair sidewalk to remove trip hazard

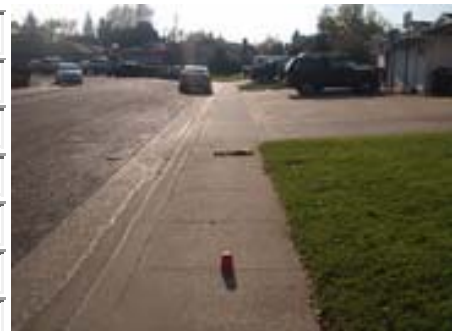
Barrier Type: Cross Slope - Existing (5.0% or more)

Description: Cross slope exceeds 2.0% (5.0% or more)

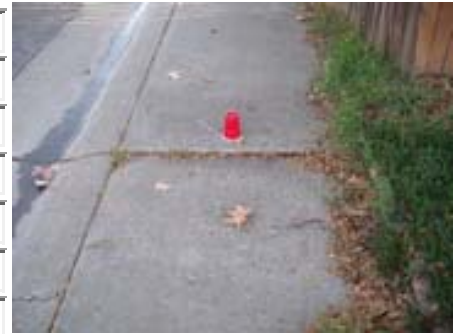
Barrier Type: Abrupt Change in Level - > 1/2"

Description: Change in level greater than 1/2"

Solution: Grind or repair sidewalk to remove trip hazard

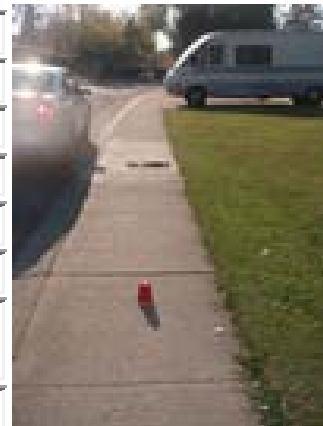
Barrier Type: Cross Slope - Existing (5.0% or more)

Description: Cross slope exceeds 2.0% (5.0% or more)

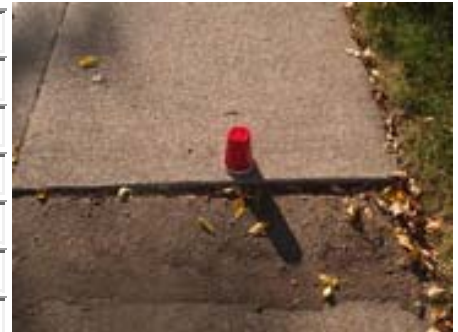
Barrier Type: Abrupt Change in Level - > 1/2"

Description: Change in level greater than 1/2"

Solution: Grind or repair sidewalk to remove trip hazard

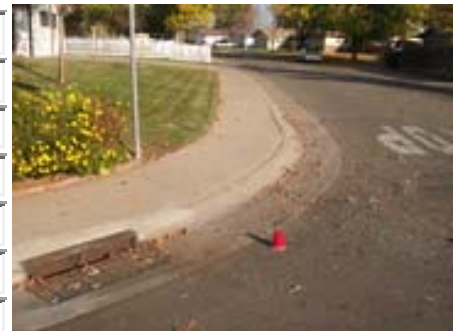
Barrier Type: No Curb Ramp

Description: No curb cut at corner (intersection)

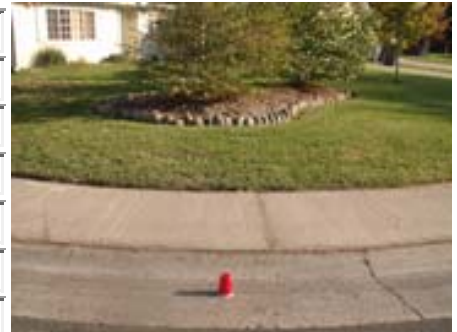
Barrier Type: No Curb Ramp

Description: No curb cut at corner (intersection)

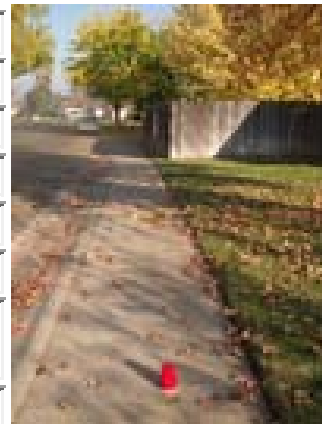
Barrier Type: Cross Slope - Existing (5.0% or more)

Description: Cross slope exceeds 2.0% (5.0% or more)

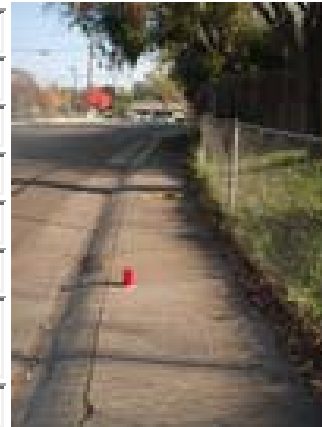
Barrier Type: Cross Slope - Existing (4.1% to 4.9%)

Description: Cross slope exceeds 2.0% (4.1% to 4.9%)

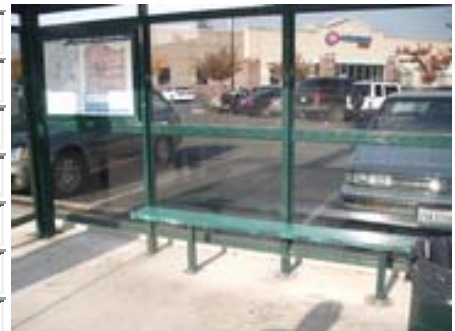
Barrier Type: Bench Seat Depth

Description: Bench seat depth not 20" - 24" deep

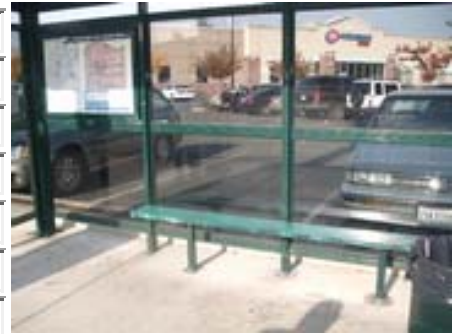
Barrier Type: Bench Back Support

Description: Bench has no back support of at least 18" high

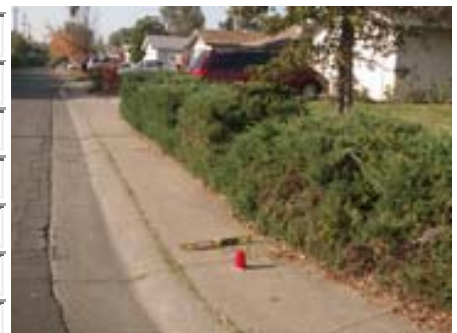
Barrier Type: Cross Slope - Existing (5.0% or more)

Description: Cross slope exceeds 2.0% (5.0% or more)

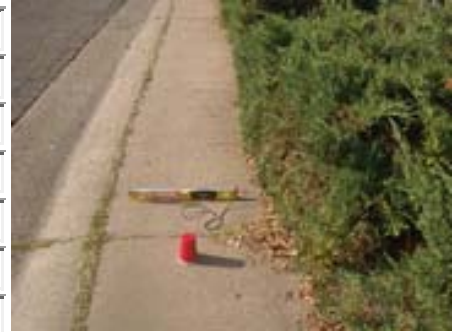
Barrier Type: Clear Width - Existing ($\leq 31"$ or less)

Description: Pedestrian route is not min. 48" wide ($\leq 31"$ or less)

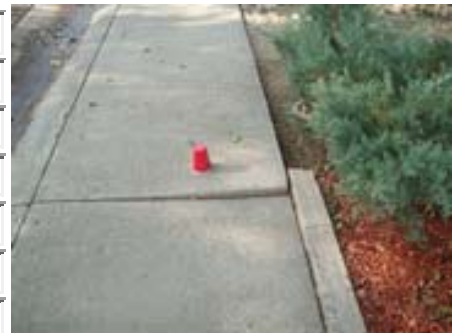
Barrier Type: Abrupt Change in Level - $> 1/2"$

Description: Change in level greater than $1/2"$

Solution: Grind or repair sidewalk to remove trip hazard

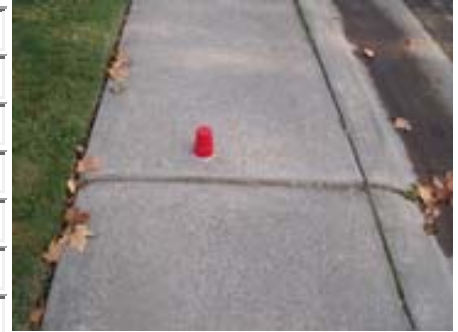
Barrier Type: Abrupt Change in Level - > 1/2"

Description: Change in level greater than 1/2"

Solution: Grind or repair sidewalk to remove trip hazard

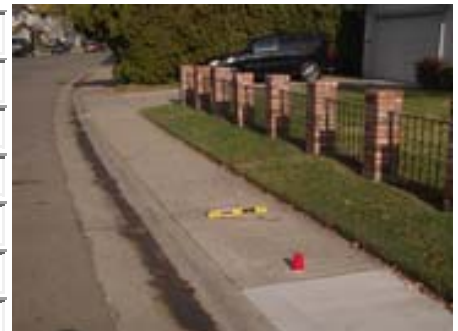
Barrier Type: Cross Slope - Existing (4.1% to 4.9%)

Description: Cross slope exceeds 2.0% (4.1% to 4.9%)

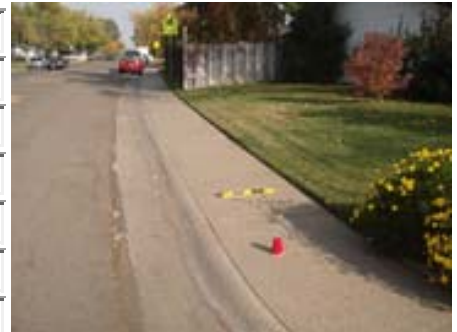
Barrier Type: Cross Slope - Existing (5.0% or more)

Description: Cross slope exceeds 2.0% (5.0% or more)

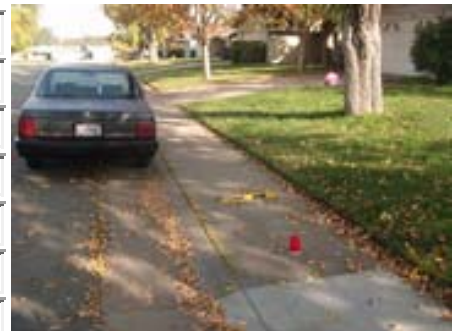
Barrier Type: Cross Slope - Existing (4.1% to 4.9%)

Description: Cross slope exceeds 2.0% (4.1% to 4.9%)

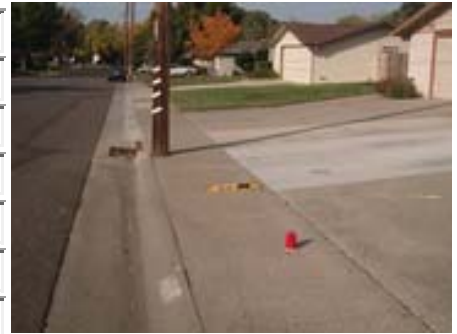
Field Date:	11/18/2010	Report Date:	11/18/2010	Barrier #:	2647A
Location:	Westbrook Dr - North				
X Coordinate:	-121.31322				
Y Coordinate:	38.68789				
Barrier Area:	Sidewalks				
Barrier Type:	Cross Slope - Existing (5.0% or more)				
Code Ref:	CBC 1133B.7.1.3 and ADA/ABA 403.3

As Built Meas:	1336	Quantity:	LF	
Description:	Cross slope exceeds 2.0% (5.0% or more)			
As Built Desc:	5.0% cross slope			
Solution:	Demolish existing and construct new route			
Bar. Severity:	1 Necessary	Cost Estimate:	\$167,000.00	Status:
Implementation Priority:	2	Facility Function:		
Implementation Phase:		Implementation Date:		
Official Responsible:				
Notes:

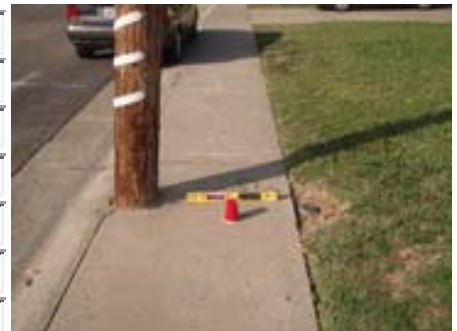
Field Date:	11/18/2010	Report Date:	11/18/2010	Barrier #:	2647B
Location:	Westbrook Dr - North				
X Coordinate:	-121.31365				
Y Coordinate:	38.68792				
Barrier Area:	Sidewalks				
Barrier Type:	Clear Width - Existing ($\leq 31"$ or less)				
Code Ref:	CBC 1133B.7.1

As Built Meas:	4	Quantity:	LF	
Description:	Pedestrian route is not min. 48" wide ($\leq 31"$ or less)			
As Built Desc:	28" clear width due to pole			
Solution:	Demolish existing and construct new route			
Bar. Severity:	1 Necessary	Cost Estimate:	\$500.00	Status:
Implementation Priority:	2	Facility Function:		
Implementation Phase:		Implementation Date:		
Official Responsible:				
Notes:

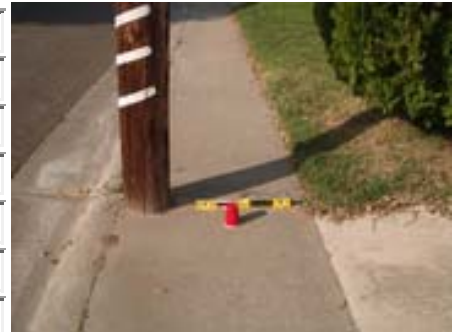
Barrier Type: Clear Width - Existing ($\leq 31"$ or less)

Description: Pedestrian route is not min. 48" wide ($\leq 31"$ or less)
