SZS CONSULTING GROUP

DRAFT ADA TRANSITION PLAN UPDATE
NEIGHBORHOOD AREA 3 CHANT
SEPTEMBER 20, 2011

CITY OF CITRUS HEIGHTS

Citrus Heights Area Three (CHANT)

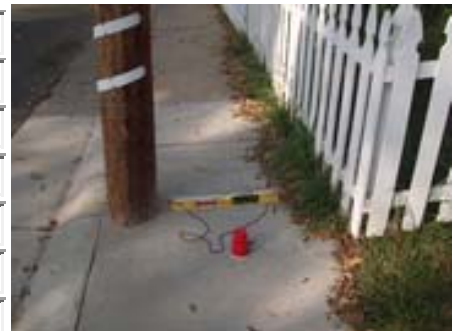
Barrier Type: Clear Width - Existing ($\leq 31"$ or less)

Description: Pedestrian route is not min. 48" wide ($\leq 31"$ or less)

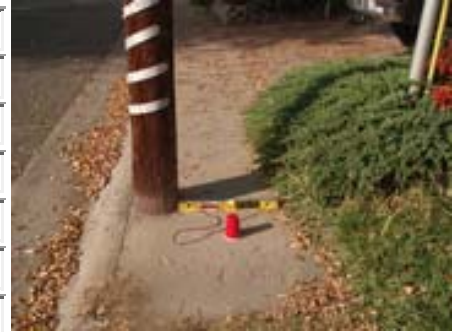
Barrier Type: Clear Width - Existing ($\leq 31"$ or less)

Description: Pedestrian route is not min. 48" wide ($\leq 31"$ or less)

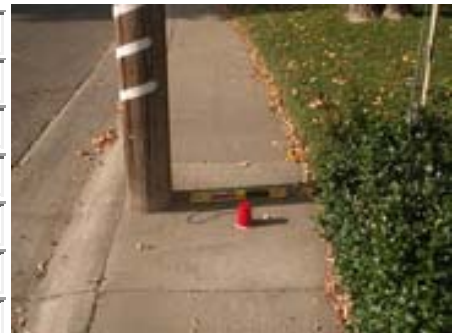
Barrier Type: Clear Width - Existing ($\leq 31"$ or less)

Description: Pedestrian route is not min. 48" wide ($\leq 31"$ or less)

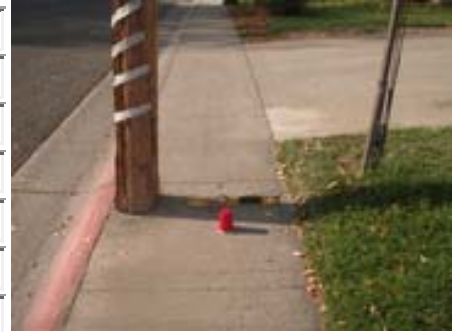
Barrier Type: Clear Width - Existing ($\leq 31"$ or less)

Description: Pedestrian route is not min. 48" wide ($\leq 31"$ or less)

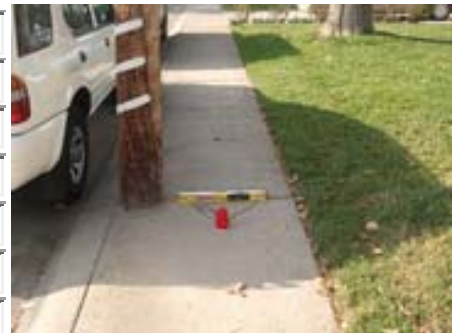
Barrier Type: Clear Width - Existing ($\leq 31"$ or less)

Description: Pedestrian route is not min. 48" wide ($\leq 31"$ or less)

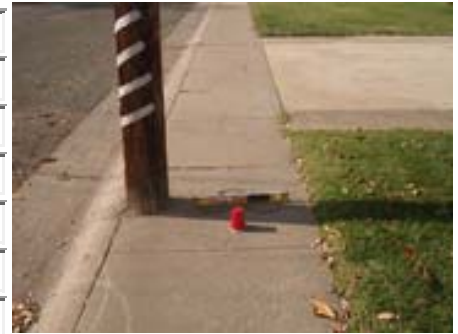
Barrier Type: Clear Width - Existing ($\leq 31"$ or less)

Description: Pedestrian route is not min. 48" wide ($\leq 31"$ or less)

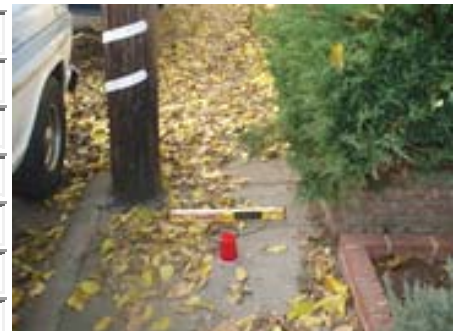
Barrier Type: Clear Width - Existing ($\leq 31"$ or less)

Description: Pedestrian route is not min. 48" wide ($\leq 31"$ or less)

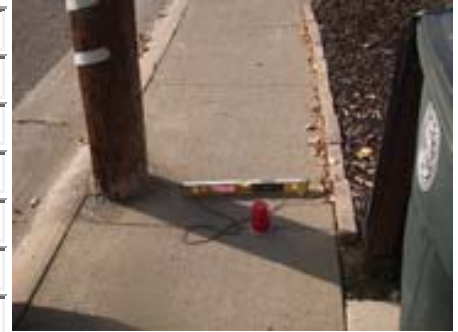
Barrier Type: Clear Width - Existing ($\leq 31"$ or less)

Description: Pedestrian route is not min. 48" wide ($\leq 31"$ or less)

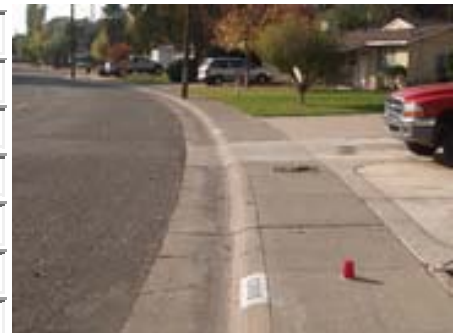
Barrier Type: Cross Slope - Existing (5.0% or more)

Description: Cross slope exceeds 2.0% (5.0% or more)

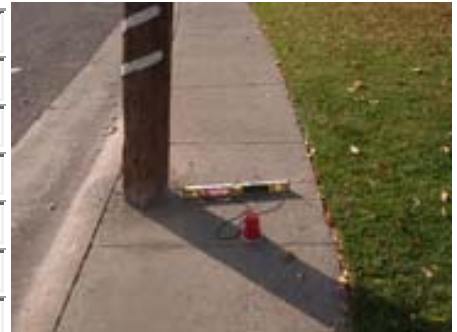
Barrier Type: Clear Width - Existing ($\leq 31"$ or less)

Description: Pedestrian route is not min. 48" wide ($\leq 31"$ or less)

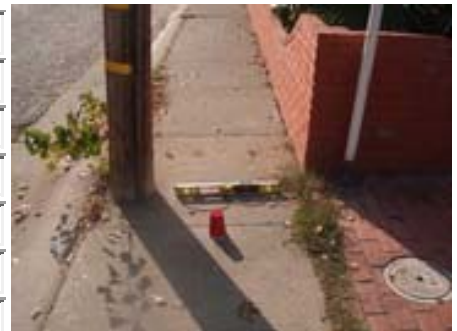
Barrier Type: Clear Width - Existing ($\leq 31"$ or less)

Description: Pedestrian route is not min. 48" wide ($\leq 31"$ or less)

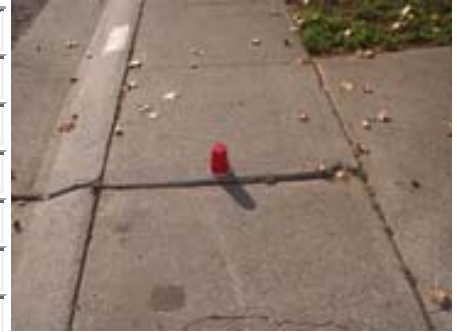
Barrier Type: Abrupt Change in Level - > 1/2"

Description: Change in level greater than 1/2"

Solution: Grind or repair sidewalk to remove trip hazard

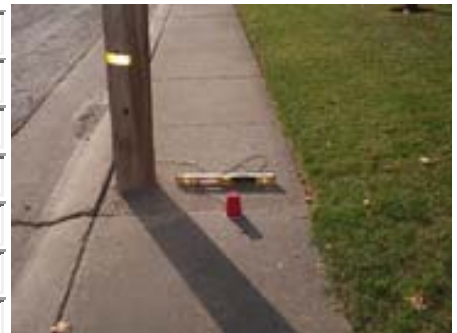
Barrier Type: Clear Width - Existing ($\leq 31"$ or less)

Description: Pedestrian route is not min. 48" wide ($\leq 31"$ or less)

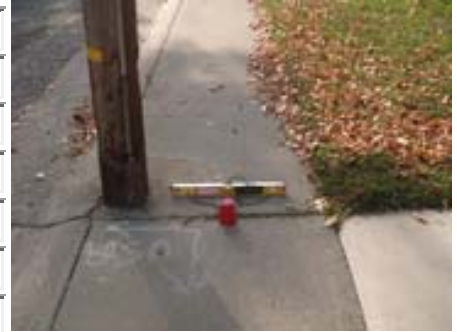
Barrier Type: Clear Width - Existing ($\leq 31"$ or less)

Description: Pedestrian route is not min. 48" wide ($\leq 31"$ or less)

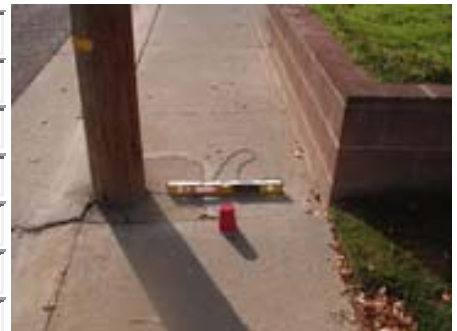
Barrier Type: Clear Width - Existing ($\leq 31"$ or less)

Description: Pedestrian route is not min. 48" wide ($\leq 31"$ or less)

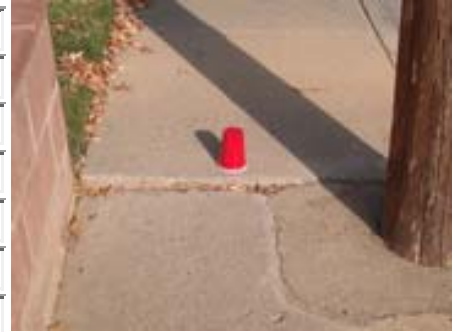
Barrier Type: Abrupt Change in Level - > 1/2"

Code Ref: CBC 1133B.7.1 and ADA/ABA 303.3

As Built Meas: 4 Quantity: LF

Description: Change in level greater than 1/2"

Solution: Grind or repair sidewalk to remove trip hazard

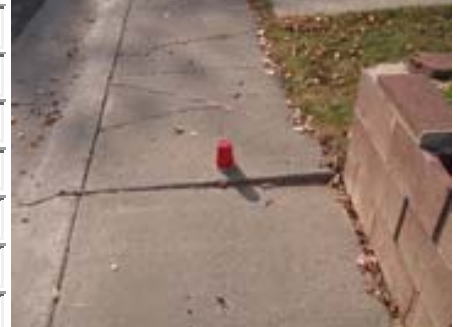
Barrier Type: Abrupt Change in Level - > 1/2"

Code Ref: CBC 1133B.7.1 and ADA/ABA 303.3

As Built Meas: 4 Quantity: LF

Description: Change in level greater than 1/2"

Solution: Grind or repair sidewalk to remove trip hazard

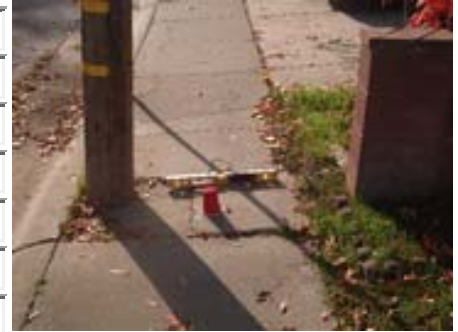
Barrier Type: Clear Width - Existing ($\leq 31"$ or less)

Code Ref: CBC 1133B.7.1

As Built Meas: 4 Quantity: LF

Description: Pedestrian route is not min. 48" wide ($\leq 31"$ or less)

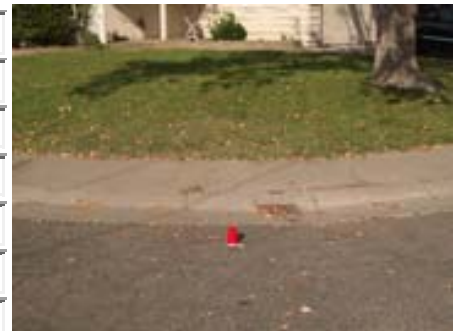
Barrier Type: No Curb Ramp

Code Ref: CBC 1127B.5.1 and ADA/ABA 402.2

As Built Meas: 1 Quantity: EACH

Description: No curb cut at corner (intersection)

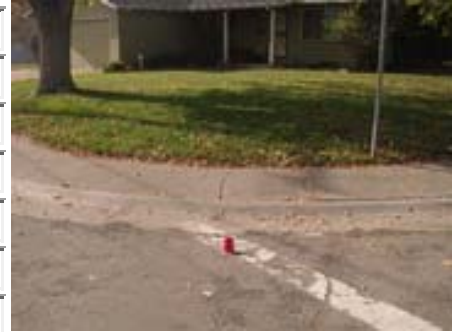
Barrier Type: No Curb Ramp

Code Ref: CBC 1127B.5.1 and ADA/ABA 402.2

As Built Meas: 1 Quantity: EACH

Description: No curb cut at corner (intersection)

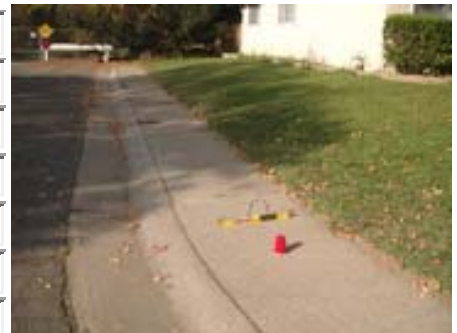
Barrier Type: Cross Slope - Existing (5.0% or more)

Code Ref: CBC 1133B.7.1.3 and ADA/ABA 403.3

As Built Meas: 88 Quantity: LF

Description: Cross slope exceeds 2.0% (5.0% or more)

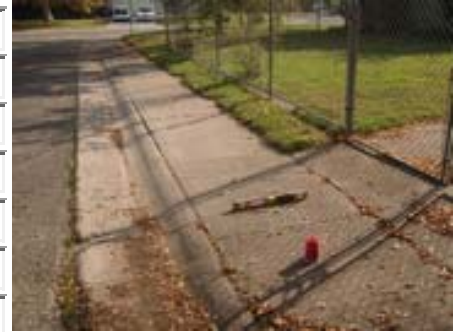
Barrier Type: Cross Slope - Existing (5.0% or more)

Code Ref: CBC 1133B.7.1.3 and ADA/ABA 403.3

As Built Meas: 86 Quantity: LF

Description: Cross slope exceeds 2.0% (5.0% or more)

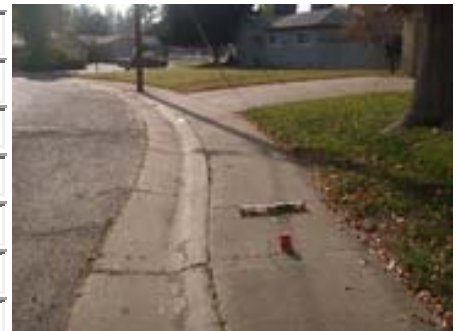
Barrier Type: Cross Slope - Existing (5.0% or more)

Code Ref: CBC 1133B.7.1.3 and ADA/ABA 403.3

As Built Meas: 121 Quantity: LF

Description: Cross slope exceeds 2.0% (5.0% or more)

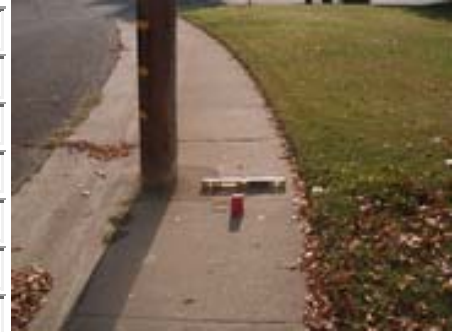
Barrier Type: Clear Width - Existing ($\leq 31"$ or less)

Code Ref: CBC 1133B.7.1

As Built Meas: 4 Quantity: LF

Description: Pedestrian route is not min. 48" wide ($\leq 31"$ or less)

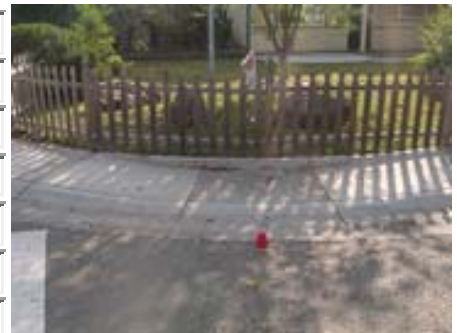
Barrier Type: Detectable Warnings - Truncated Domes

Code Ref: CBC 1127B.5.7 and ADA/ABA 705.1.3

As Built Meas: 1 Quantity: EACH

Description: No truncated domes provided at curb ramp

Bar. Severity: 2 Recommended Cost Estimate: \$1,400.00 Status:

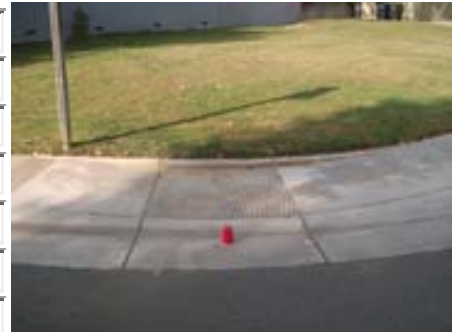
Barrier Type: Gutter Slope - Existing (6.6% to 8.2%)

Code Ref: CBC 1127B.5.3 and ADA/ABA 406.2

As Built Meas: 6 Quantity: SF

Description: Gutter slope exceeds 5.0% (6.6% to 8.2%)

Bar. Severity: 2 Recommended Cost Estimate: \$750.00 Status:

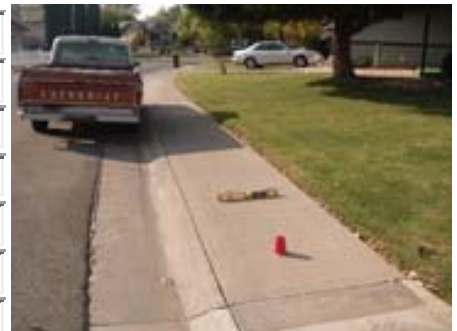
Barrier Type: Cross Slope - New Construction

Code Ref: CBC 1133B.7.1.3 and ADA/ABA 403.3

As Built Meas: 209 Quantity: LF

Description: Cross slope exceeds 2.0% in new construction

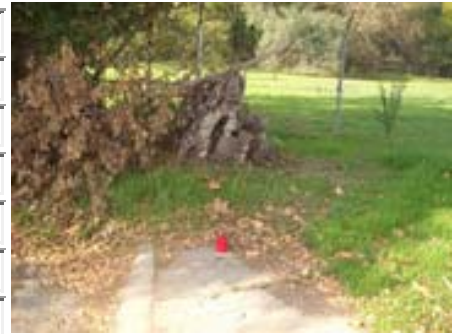
Barrier Type: No Sidewalk - No Barricade

Code Ref: MUTCD Section 6D.01

As Built Meas: 1 Quantity: JOB

Description: No barricade provided where sidewalk ends in hazardous location

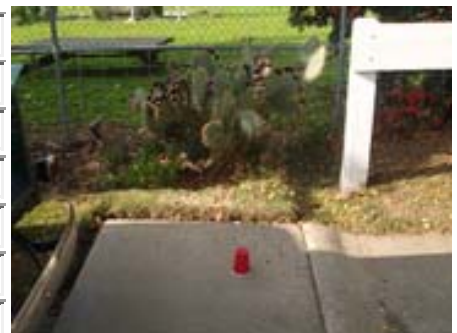
Barrier Type: No Sidewalk - No Barricade

Code Ref: MUTCD Section 6D.01

As Built Meas: 1 Quantity: JOB

Description: No barricade provided where sidewalk ends in hazardous location

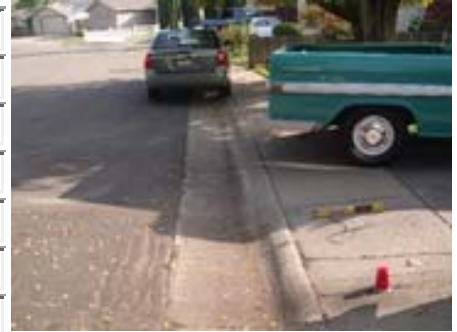
Barrier Type: Cross Slope - Existing (5.0% or more)

Code Ref: CBC 1133B.7.1.3 and ADA/ABA 403.3

As Built Meas: 146 Quantity: LF

Description: Cross slope exceeds 2.0% (5.0% or more)

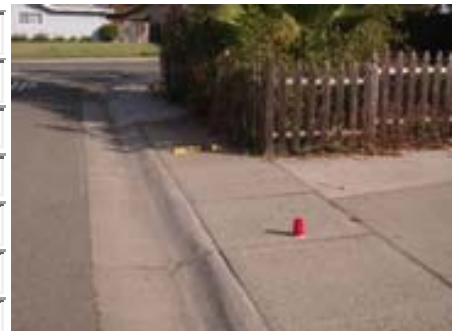
Barrier Type: Cross Slope - Existing (5.0% or more)

Code Ref: CBC 1133B.7.1.3 and ADA/ABA 403.3

As Built Meas: 39 Quantity: LF

Description: Cross slope exceeds 2.0% (5.0% or more)

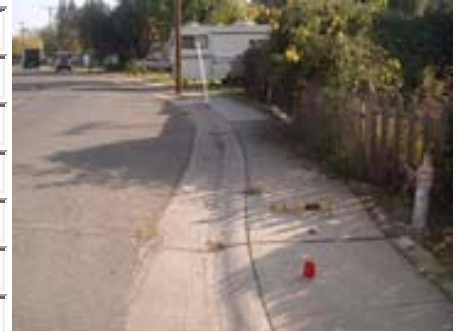
Barrier Type: Cross Slope - Existing (5.0% or more)

Code Ref: CBC 1133B.7.1.3 and ADA/ABA 403.3

As Built Meas: 1010 Quantity: LF

Description: Cross slope exceeds 2.0% (5.0% or more)

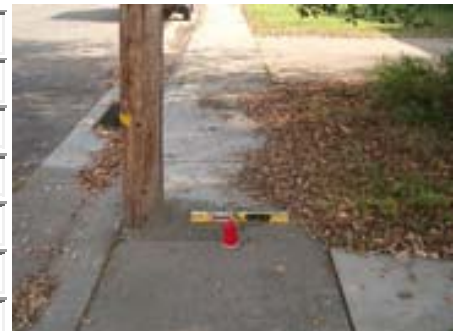
Barrier Type: Clear Width - Existing ($\leq 31"$ or less)

Code Ref: CBC 1133B.7.1

As Built Meas: 4 Quantity: LF

Description: Pedestrian route is not min. 48" wide ($\leq 31"$ or less)

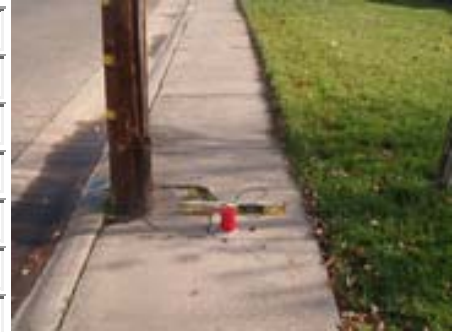
Barrier Type: Clear Width - Existing ($\leq 31"$ or less)

Code Ref: CBC 1133B.7.1

As Built Meas: 4 Quantity: LF

Description: Pedestrian route is not min. 48" wide ($\leq 31"$ or less)

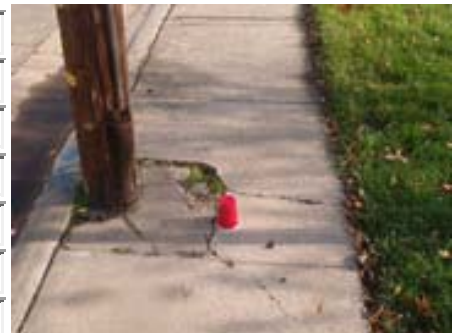
Barrier Type: Surface Condition - Damaged

Code Ref: CBC 1133B.7.1 and ADA/ABA 302.1

As Built Meas: 4 Quantity: LF

Description: Surface is not firm and stable (cracked, broken or loose soil, etc.)

As Built Desc: Cracked concrete

Solution: Repair surface to make firm and stable

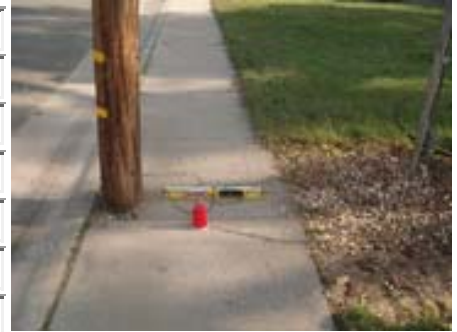
Field Date:	11/18/2010	Report Date:	11/18/2010	Barrier #:	2660E
Location:	Westbrook Dr - South				
X Coordinate:	-121.31593				
Y Coordinate:	38.68363				
Barrier Area:	Sidewalks				
Barrier Type:	Clear Width - Existing ($\leq 31"$ or less)				
Code Ref:	CBC 1133B.7.1

As Built Meas:	4	Quantity:	LF	
Description:	Pedestrian route is not min. 48" wide ($\leq 31"$ or less)			
As Built Desc:	30" clear width due to pole			
Solution:	Demolish existing and construct new route			
Bar. Severity:	1 Necessary	Cost Estimate:	\$500.00	Status:
Implementation Priority:	2	Facility Function:		
Implementation Phase:		Implementation Date:		
Official Responsible:				
Notes:

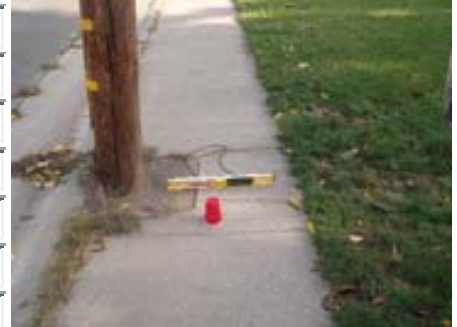
Field Date:	11/18/2010	Report Date:	11/18/2010	Barrier #:	2660F
Location:	Westbrook Dr - South				
X Coordinate:	-121.31557				
Y Coordinate:	38.68375				
Barrier Area:	Sidewalks				
Barrier Type:	Clear Width - Existing ($\leq 31"$ or less)				
Code Ref:	CBC 1133B.7.1

As Built Meas:	4	Quantity:	LF	
Description:	Pedestrian route is not min. 48" wide ($\leq 31"$ or less)			
As Built Desc:	28" clear width due to pole			
Solution:	Demolish existing and construct new route			
Bar. Severity:	1 Necessary	Cost Estimate:	\$500.00	Status:
Implementation Priority:	2	Facility Function:		
Implementation Phase:		Implementation Date:		
Official Responsible:				
Notes:

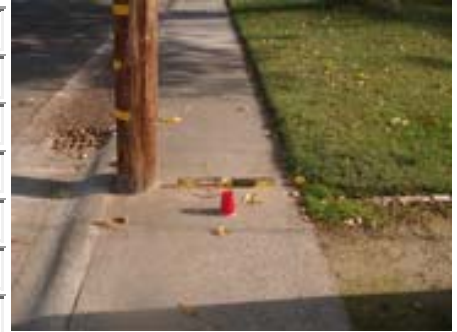
Barrier Type: Clear Width - Existing ($\leq 31"$ or less)

Code Ref: CBC 1133B.7.1

As Built Meas: 4 Quantity: LF

Description: Pedestrian route is not min. 48" wide ($\leq 31"$ or less)

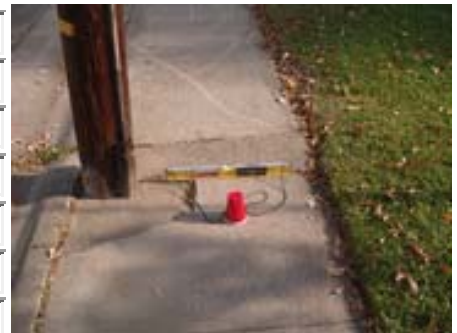
Barrier Type: Clear Width - Existing ($\leq 31"$ or less)

Code Ref: CBC 1133B.7.1

As Built Meas: 4 Quantity: LF

Description: Pedestrian route is not min. 48" wide ($\leq 31"$ or less)

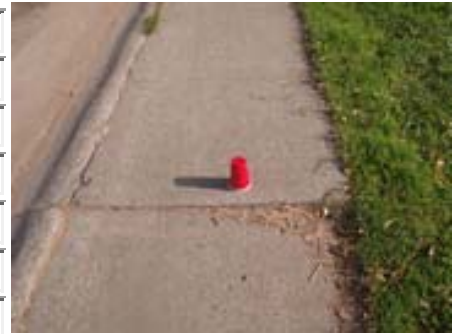
Barrier Type: Abrupt Change in Level - > 1/2"

Code Ref: CBC 1133B.7.1 and ADA/ABA 303.3

As Built Meas: 4 Quantity: LF

Description: Change in level greater than 1/2"

Solution: Grind or repair sidewalk to remove trip hazard

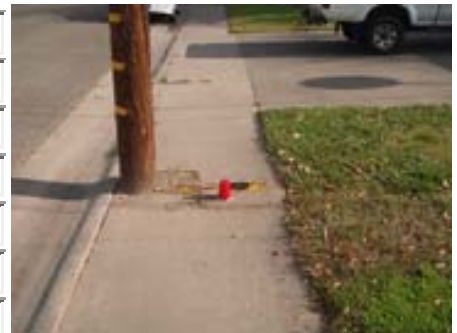
Barrier Type: Clear Width - Existing ($\leq 31"$ or less)

Code Ref: CBC 1133B.7.1

As Built Meas: 4 Quantity: LF

Description: Pedestrian route is not min. 48" wide ($\leq 31"$ or less)

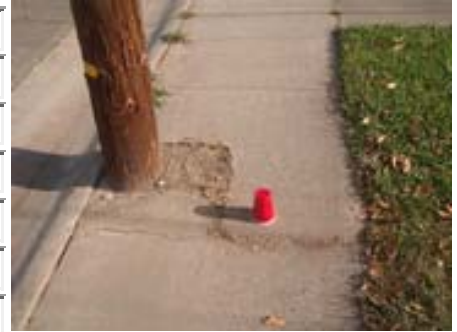
Barrier Type: Surface Condition - Damaged

Code Ref: CBC 1133B.7.1 and ADA/ABA 302.1

As Built Meas: 4 Quantity: LF

Description: Surface is not firm and stable (cracked, broken or loose soil, etc.)

As Built Desc: Cracked concrete

Solution: Repair surface to make firm and stable

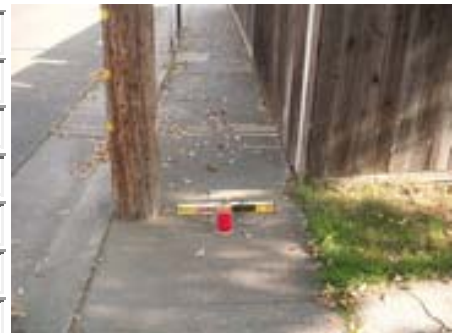
Barrier Type: Clear Width - Existing ($\leq 31''$ or less)

Code Ref: CBC 1133B.7.1

As Built Meas: 4 Quantity: LF

Description: Pedestrian route is not min. 48" wide ($\leq 31''$ or less)

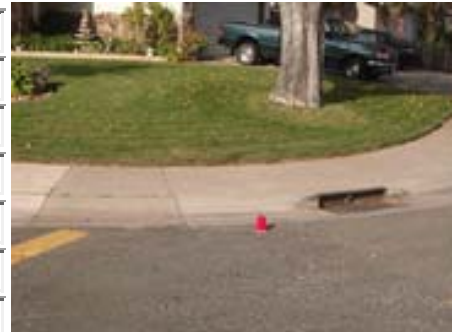
Barrier Type: No Curb Ramp

Code Ref: CBC 1127B.5.1 and ADA/ABA 402.2

As Built Meas: 1 Quantity: EACH

Description: No curb cut at corner (intersection)

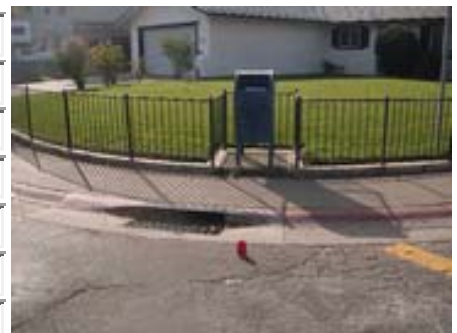
Barrier Type: No Curb Ramp

Code Ref: CBC 1127B.5.1 and ADA/ABA 402.2

As Built Meas: 1 Quantity: EACH

Description: No curb cut at corner (intersection)

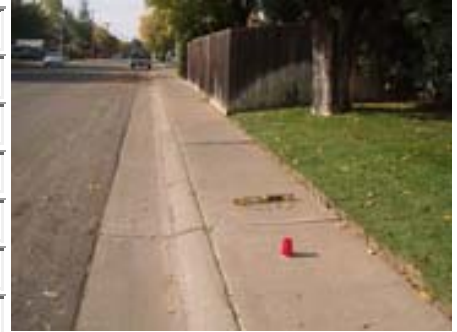
Barrier Type: Cross Slope - Existing (5.0% or more)

Code Ref: CBC 1133B.7.1.3 and ADA/ABA 403.3

As Built Meas: 1232 Quantity: LF

Description: Cross slope exceeds 2.0% (5.0% or more)

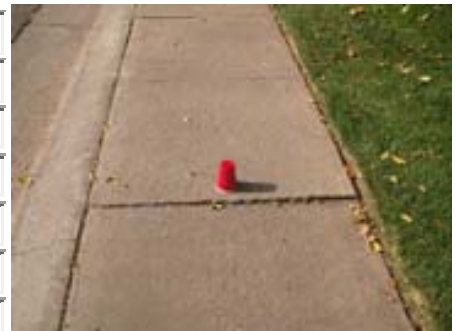
Barrier Type: Abrupt Change in Level - > 1/2"

Code Ref: CBC 1133B.7.1 and ADA/ABA 303.3

As Built Meas: 4 Quantity: LF

Description: Change in level greater than 1/2"

Solution: Grind or repair sidewalk to remove trip hazard

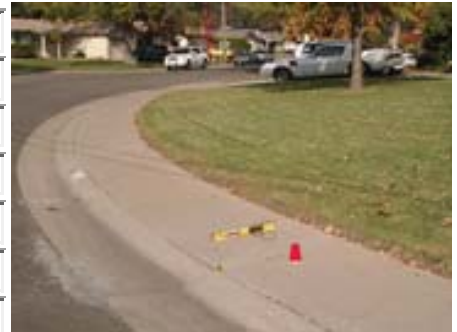
Field Date:	11/18/2010	Report Date:	11/18/2010	Barrier #:	2664
Location:	Westbrook Dr - East				
X Coordinate:	-121.3174				
Y Coordinate:	38.68355				
Barrier Area:	Sidewalks				
Barrier Type:	Cross Slope - Existing (5.0% or more)				
Code Ref:	CBC 1133B.7.1.3 and ADA/ABA 403.3

As Built Meas:	194	Quantity:	LF
Description:	Cross slope exceeds 2.0% (5.0% or more)		
As Built Desc:	5.1% cross slope		
Solution:	Demolish existing and construct new route		
Bar. Severity:	1 Necessary	Cost Estimate:	\$24,250.00
Implementation Priority:	2	Facility Function:	
Implementation Phase:		Implementation Date:	
Official Responsible:

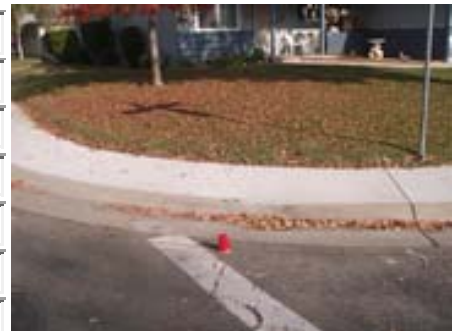
Field Date:	11/18/2010	Report Date:	11/18/2010	Barrier #:	2665
Location:	Westbrook Dr and Cheltenham Wy - Corner B				
X Coordinate:	-121.3175				
Y Coordinate:	38.68417				
Barrier Area:	Curb Ramps				
Barrier Type:	No Curb Ramp				
Code Ref:	CBC 1127B.5.1 and ADA/ABA 402.2

As Built Meas:	1	Quantity:	EACH
Description:	No curb cut at corner (intersection)		
As Built Desc:	No curb ramp at corner		
Solution:	Demolish existing and construct curb cut		
Bar. Severity:	1 Necessary	Cost Estimate:	\$2,500.00
Implementation Priority:	2	Facility Function:	
Implementation Phase:		Implementation Date:	
Official Responsible:

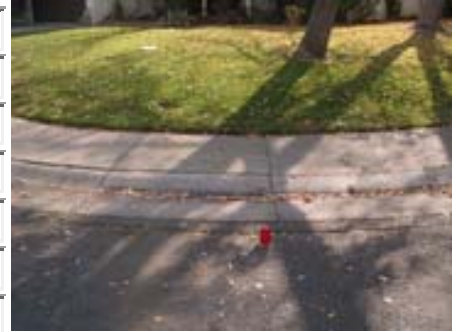
Barrier Type: No Curb Ramp

Code Ref: CBC 1127B.5.1 and ADA/ABA 402.2

As Built Meas: 1 Quantity: EACH

Description: No curb cut at corner (intersection)

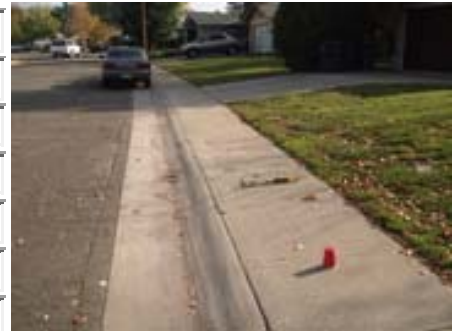
Barrier Type: Cross Slope - Existing (4.1% to 4.9%)

Code Ref: CBC 1133B.7.1.3 and ADA/ABA 403.3

As Built Meas: 43 Quantity: LF

Description: Cross slope exceeds 2.0% (4.1% to 4.9%)

Bar. Severity: 2 Recommended Cost Estimate: \$5,375.00 Status:

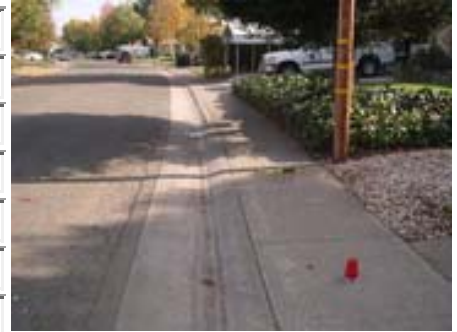
Barrier Type: Cross Slope - Existing (5.0% or more)

Code Ref: CBC 1133B.7.1.3 and ADA/ABA 403.3

As Built Meas: 903 Quantity: LF

Description: Cross slope exceeds 2.0% (5.0% or more)

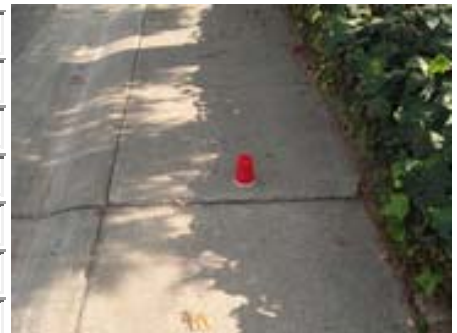
Barrier Type: Abrupt Change in Level - > 1/2"

Code Ref: CBC 1133B.7.1 and ADA/ABA 303.3

As Built Meas: 4 Quantity: LF

Description: Change in level greater than 1/2"

Solution: Grind or repair sidewalk to remove trip hazard

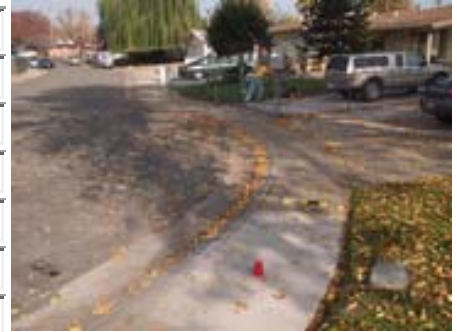
Barrier Type: Cross Slope - Existing (4.1% to 4.9%)

Code Ref: CBC 1133B.7.1.3 and ADA/ABA 403.3

As Built Meas: 276 Quantity: LF

Description: Cross slope exceeds 2.0% (4.1% to 4.9%)

Bar. Severity: 2 Recommended

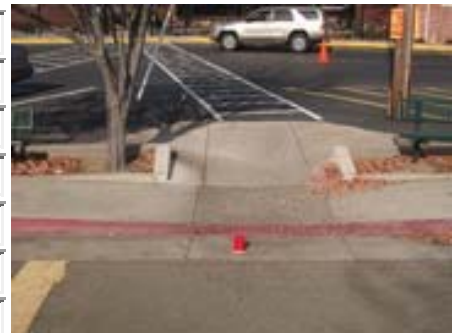
Barrier Type: 12" Grooves - Existing (3.1% to 4.0%)

Code Ref: CBC 1127B.5.6

As Built Meas: 1 Quantity: EACH

Description: 12" grooves at top of curb ramp are not level (3.1% to 4.0%)

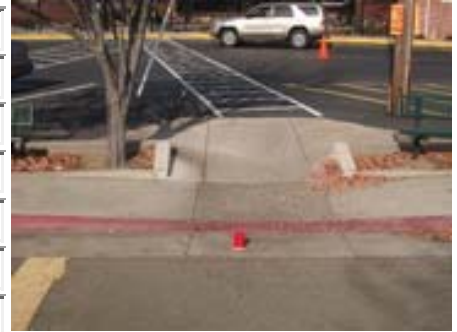
Barrier Type: Cross Slope - Existing (4.1% to 4.9%)

Code Ref: CBC 1127B.5.3 and ADA/ABA 406.2

As Built Meas: 1 Quantity: EACH

Description: Ramp run cross slope exceeds 2.0% (4.1% to 4.9%)

Bar. Severity: 2 Recommended

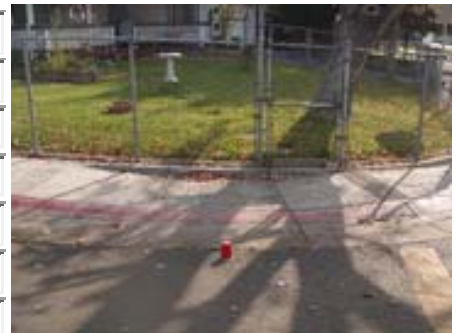
Barrier Type: 12" Grooves - Existing (>5.0%)

Code Ref: CBC 1127B.5.6

As Built Meas: 1 Quantity: EACH

Description: 12" grooves at top of curb ramp are not level (>5.0%)

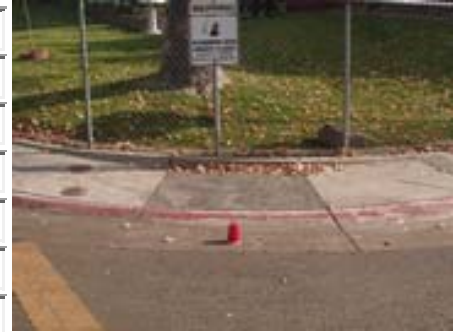
Barrier Type: Parallel Ramp Landing - Existing (4.1% to 4.9%)

Code Ref: CBC 1127B.5.4 and ADA/ABA 406.4

As Built Meas: 1 Quantity: EACH

Description: Curb ramp landing or pan not level(4.1% to 4.9%)

Bar. Severity: 2 Recommended

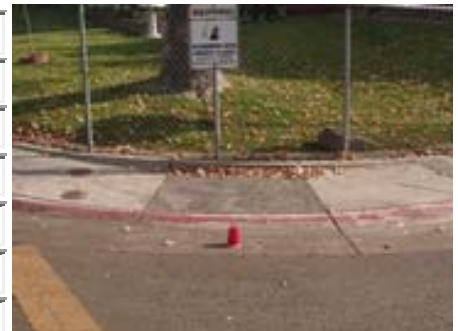
Barrier Type: Detectable Warnings - Truncated Domes

Code Ref: CBC 1127B.5.7 and ADA/ABA 705.1.3

As Built Meas: 1 Quantity: EACH

Description: No truncated domes provided at curb ramp

Bar. Severity: 2 Recommended

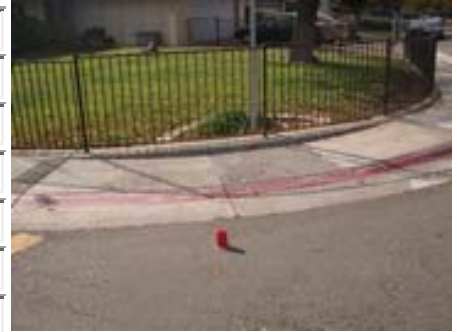
Barrier Type: Detectable Warnings - Truncated Domes

Code Ref: CBC 1127B.5.7 and ADA/ABA 705.1.3

As Built Meas: 1 Quantity: EACH

Description: No truncated domes provided at curb ramp

Bar. Severity: 2 Recommended Cost Estimate: \$1,400.00 Status:

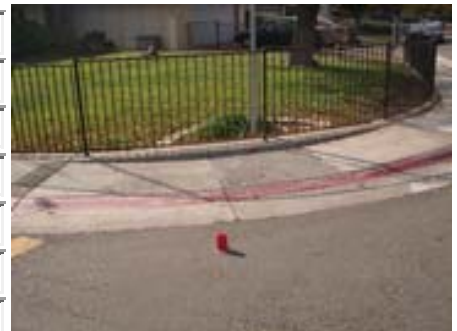
Barrier Type: Gutter Slope - Existing (8.3% or more)

Code Ref: CBC 1127B.5.3 and ADA/ABA 406.2

As Built Meas: 6 Quantity: SF

Description: Gutter slope exceeds 5.0% (8.3% or more)

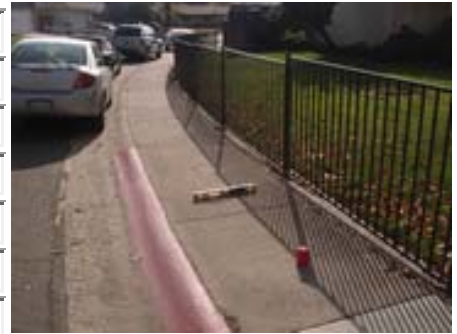
Barrier Type: Cross Slope - Existing (5.0% or more)

Code Ref: CBC 1133B.7.1.3 and ADA/ABA 403.3

As Built Meas: 221 Quantity: LF

Description: Cross slope exceeds 2.0% (5.0% or more)

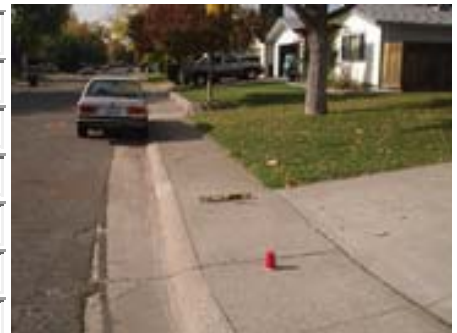
Barrier Type: Cross Slope - Existing (4.1% to 4.9%)

Code Ref: CBC 1133B.7.1.3 and ADA/ABA 403.3

As Built Meas: 821 Quantity: LF

Description: Cross slope exceeds 2.0% (4.1% to 4.9%)

Bar. Severity: 2 Recommended Cost Estimate: \$102,625.00 Status:

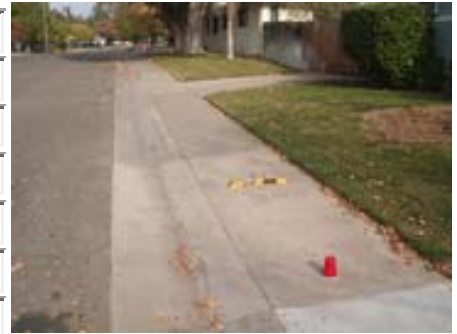
Field Date:	11/18/2010	Report Date:	11/18/2010	Barrier #:	2675
Location:	Westbrook Dr - West				
X Coordinate:	-121.31752				
Y Coordinate:	38.68434				
Barrier Area:	Sidewalks				
Barrier Type:	Cross Slope - Existing (5.0% or more)				
Code Ref:	CBC 1133B.7.1.3 and ADA/ABA 403.3

As Built Meas:	150	Quantity:	LF
Description:	Cross slope exceeds 2.0% (5.0% or more)		
As Built Desc:	5.6% cross slope		
Solution:	Demolish existing and construct new route		
Bar. Severity:	1 Necessary	Cost Estimate:	\$18,750.00
Implementation Priority:	2	Facility Function:	
Implementation Phase:		Implementation Date:	
Official Responsible:

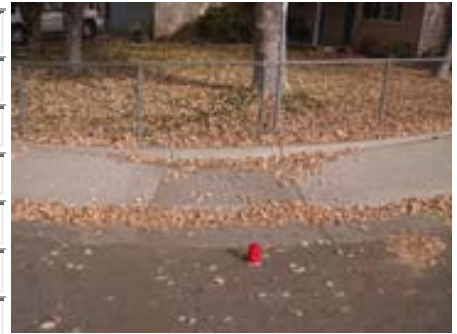
Barrier Type: Cross Slope - Existing (3.1% to 4.0%)

Code Ref: CBC 1127B.5.3 and ADA/ABA 406.2

As Built Meas: 1 Quantity: EACH

Description: Ramp run cross slope exceeds 2.0% (3.1% to 4.0%)

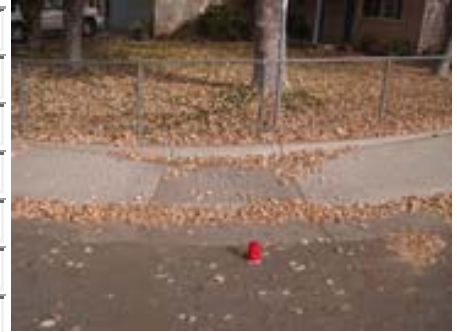
Barrier Type: Detectable Warnings - Truncated Domes

Code Ref: CBC 1127B.5.7 and ADA/ABA 705.1.3

As Built Meas: 1 Quantity: EACH

Description: No truncated domes provided at curb ramp

Bar. Severity: 2 Recommended Cost Estimate: \$0.00 Status:

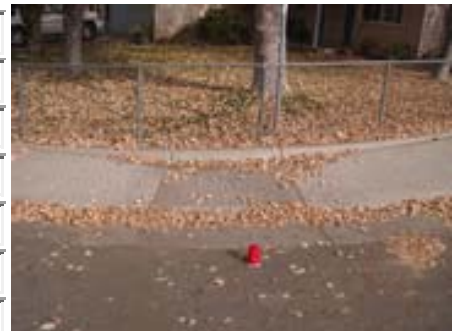
Barrier Type: Gutter Slope - Existing (8.3% or more)

Code Ref: CBC 1127B.5.3 and ADA/ABA 406.2

As Built Meas: 6 Quantity: SF

Description: Gutter slope exceeds 5.0% (8.3% or more)

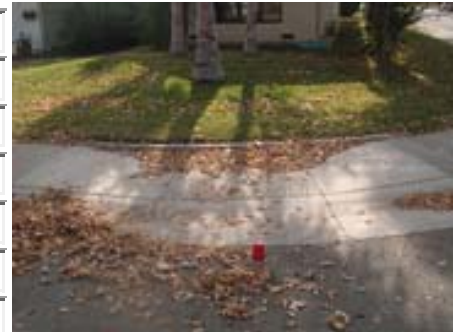
Barrier Type: 12" Grooves - Existing (3.1% to 4.0%)

Code Ref: CBC 1127B.5.6

As Built Meas: 1 Quantity: EACH

Description: 12" grooves at top of curb ramp are not level (3.1% to 4.0%)

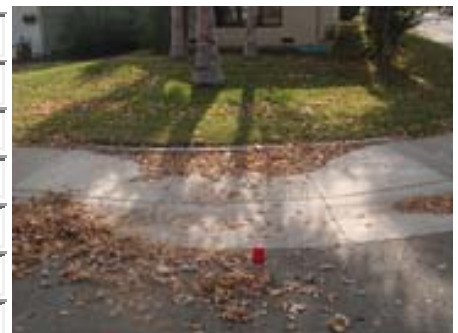
Barrier Type: Detectable Warnings - Truncated Domes

Code Ref: CBC 1127B.5.7 and ADA/ABA 705.1.3

As Built Meas: 1 Quantity: EACH

Description: No truncated domes provided at curb ramp

Bar. Severity: 2 Recommended Cost Estimate: \$0.00 Status:

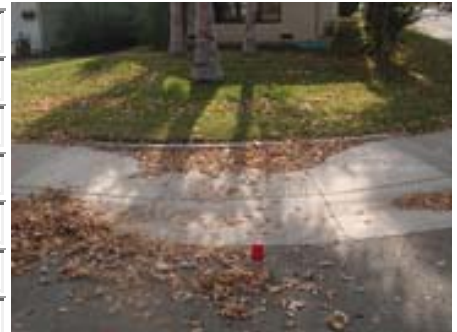
Barrier Type: Gutter Slope - Existing (6.6% to 8.2%)

Code Ref: CBC 1127B.5.3 and ADA/ABA 406.2

As Built Meas: 6 Quantity: SF

Description: Gutter slope exceeds 5.0% (6.6% to 8.2%)

Bar. Severity: 2 Recommended Cost Estimate: \$0.00 Status:

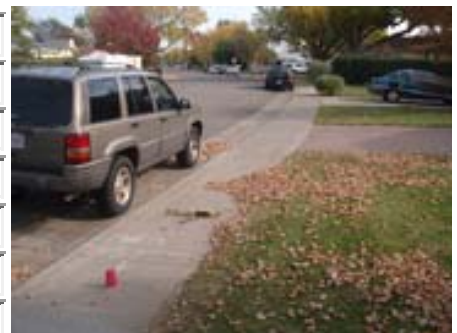
Barrier Type: Cross Slope - Existing (5.0% or more)

Code Ref: CBC 1133B.7.1.3 and ADA/ABA 403.3

As Built Meas: 877 Quantity: LF

Description: Cross slope exceeds 2.0% (5.0% or more)

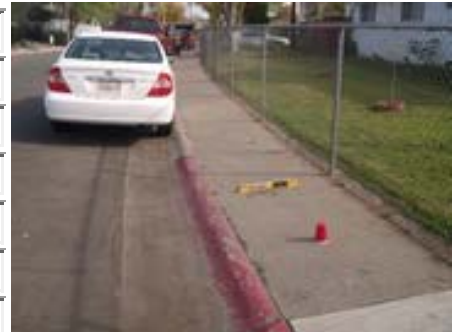
Barrier Type: Cross Slope - Existing (5.0% or more)

Code Ref: CBC 1133B.7.1.3 and ADA/ABA 403.3

As Built Meas: 217 Quantity: LF

Description: Cross slope exceeds 2.0% (5.0% or more)

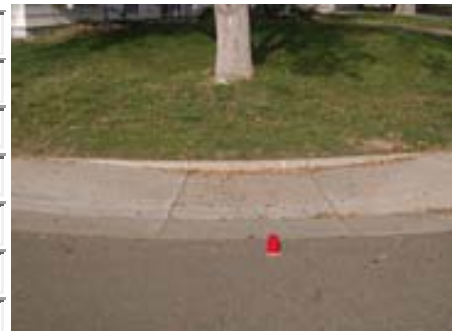
Barrier Type: 12" Grooves - Existing (4.1% to 4.9%)

Code Ref: CBC 1127B.5.6

As Built Meas: 1 Quantity: EACH

Description: 12" grooves at top of curb ramp are not level (4.1% to 4.9%)

Bar. Severity: 2 Recommended Cost Estimate: \$2,500.00 Status:

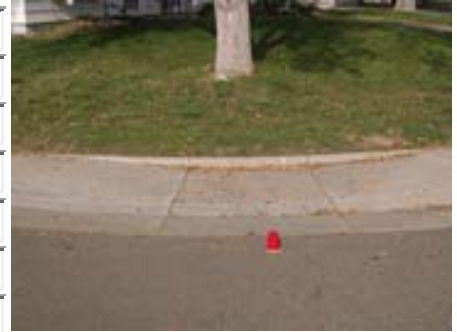
Barrier Type: Detectable Warnings - Truncated Domes

Code Ref: CBC 1127B.5.7 and ADA/ABA 705.1.3

As Built Meas: 1 Quantity: EACH

Description: No truncated domes provided at curb ramp

Bar. Severity: 2 Recommended Cost Estimate: \$0.00 Status:

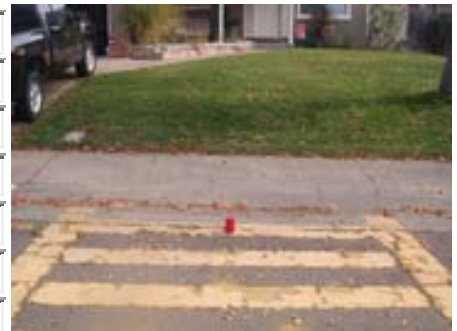
Barrier Type: No Curb Ramp

Code Ref: CBC 1127B.5.1 and ADA/ABA 402.2

As Built Meas: 1 Quantity: EACH

Description: No curb cut at corner (intersection)

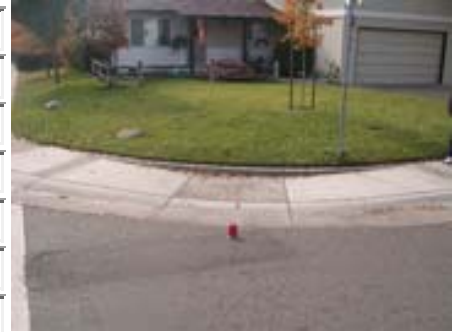
Barrier Type: Detectable Warnings - Truncated Domes

Code Ref: CBC 1127B.5.7 and ADA/ABA 705.1.3

As Built Meas: 1 Quantity: EACH

Description: No truncated domes provided at curb ramp

Bar. Severity: 2 Recommended Cost Estimate: \$1,400.00 Status:

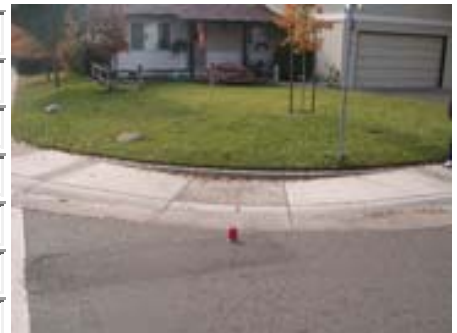
Barrier Type: Gutter Slope - Existing (8.3% or more)

Code Ref: CBC 1127B.5.3 and ADA/ABA 406.2

As Built Meas: 6 Quantity: SF

Description: Gutter slope exceeds 5.0% (8.3% or more)

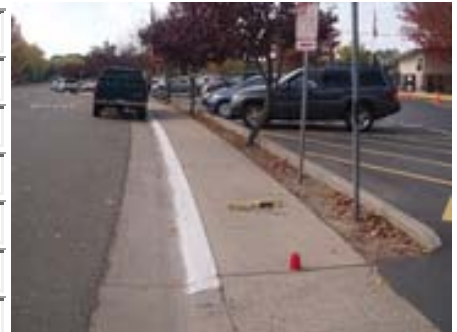
Field Date:	11/18/2010	Report Date:	11/18/2010	Barrier #:	2685
Location:	Trenton Wy - North				
X Coordinate:	-121.31406				
Y Coordinate:	38.68606				
Barrier Area:	Sidewalks				
Barrier Type:	Cross Slope - Existing (5.0% or more)				
Code Ref:	CBC 1133B.7.1.3 and ADA/ABA 403.3

As Built Meas:	87	Quantity:	LF
Description:	Cross slope exceeds 2.0% (5.0% or more)		
As Built Desc:	6.1% cross slope		
Solution:	Demolish existing and construct new route		
Bar. Severity:	1 Necessary	Cost Estimate:	\$10,875.00
Implementation Priority:	4	Facility Function:	
Implementation Phase:		Implementation Date:	
Official Responsible:			
Notes:

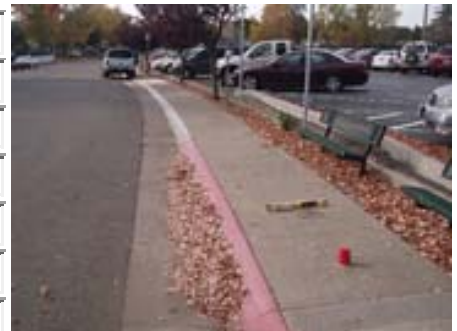
Field Date:	11/18/2010	Report Date:	11/18/2010	Barrier #:	2686
Location:	Trenton Wy - North				
X Coordinate:	-121.31442				
Y Coordinate:	38.68589				
Barrier Area:	Sidewalks				
Barrier Type:	Cross Slope - Existing (5.0% or more)				
Code Ref:	CBC 1133B.7.1.3 and ADA/ABA 403.3

As Built Meas:	229	Quantity:	LF
Description:	Cross slope exceeds 2.0% (5.0% or more)		
As Built Desc:	8.3% cross slope		
Solution:	Demolish existing and construct new route		
Bar. Severity:	1 Necessary	Cost Estimate:	\$28,625.00
Implementation Priority:	4	Facility Function:	
Implementation Phase:		Implementation Date:	
Official Responsible:			
Notes:

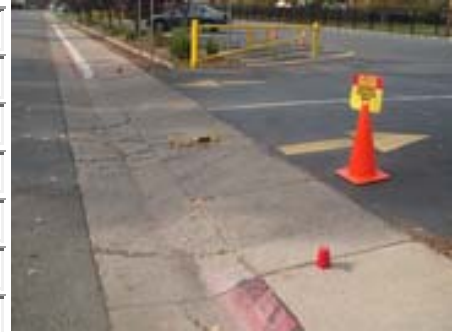
Barrier Type: Driveway - Existing (5.0% or more)

Code Ref: CBC 1133B.7.1.3 and ADA/ABA 403.3

As Built Meas: 31 Quantity: LF

Description: Driveway cross slope exceeds 2.0% (5.0% or more)

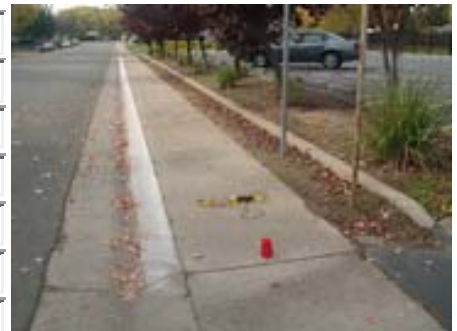
Barrier Type: Cross Slope - Existing (4.1% to 4.9%)

Code Ref: CBC 1133B.7.1.3 and ADA/ABA 403.3

As Built Meas: 143 Quantity: LF

Description: Cross slope exceeds 2.0% (4.1% to 4.9%)

Bar. Severity: 2 Recommended Cost Estimate: \$17,875.00 Status:

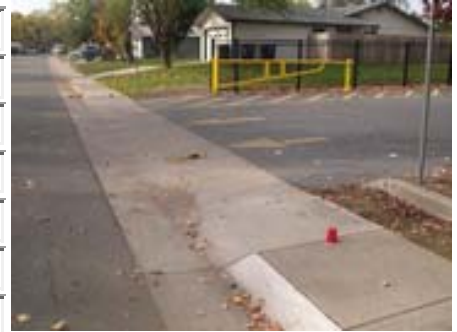
Barrier Type: Driveway - Existing (5.0% or more)

Code Ref: CBC 1133B.7.1.3 and ADA/ABA 403.3

As Built Meas: 43 Quantity: LF

Description: Driveway cross slope exceeds 2.0% (5.0% or more)

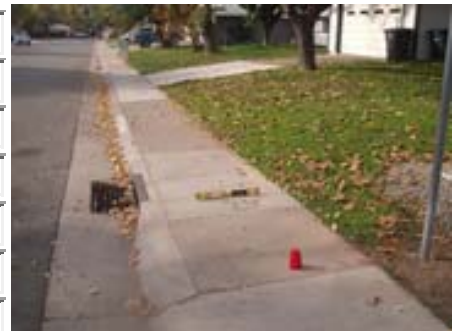
Barrier Type: Cross Slope - Existing (5.0% or more)

Code Ref: CBC 1133B.7.1.3 and ADA/ABA 403.3

As Built Meas: 519 Quantity: LF

Description: Cross slope exceeds 2.0% (5.0% or more)

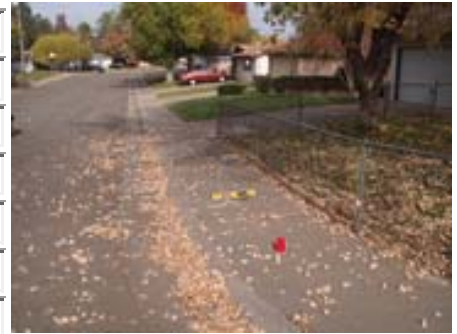
Field Date:	11/18/2010	Report Date:	11/18/2010	Barrier #:	2691
Location:	Westbrook Dr - East				
X Coordinate:	-121.31754				
Y Coordinate:	38.6849				
Barrier Area:	Sidewalks				
Barrier Type:	Cross Slope - Existing (5.0% or more)				
Code Ref:	CBC 1133B.7.1.3 and ADA/ABA 403.3

As Built Meas:	306	Quantity:	LF	
Description:	Cross slope exceeds 2.0% (5.0% or more)			
As Built Desc:	7.0% cross slope			
Solution:	Demolish existing and construct new route			
Bar. Severity:	1 Necessary	Cost Estimate:	\$38,250.00	Status:
Implementation Priority:	2	Facility Function:		
Implementation Phase:		Implementation Date:		
Official Responsible:

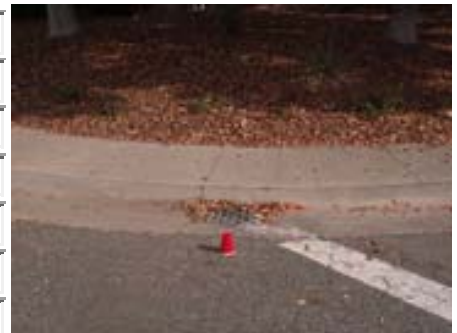
Field Date:	11/18/2010	Report Date:	11/18/2010	Barrier #:	2692
Location:	Westbrook Dr and Cardigan Ct - Corner B				
X Coordinate:	-121.31739				
Y Coordinate:	38.68587				
Barrier Area:	Curb Ramps				
Barrier Type:	No Curb Ramp				
Code Ref:	CBC 1127B.5.1 and ADA/ABA 402.2

As Built Meas:	1	Quantity:	EACH	
Description:	No curb cut at corner (intersection)			
As Built Desc:	No curb ramp at corner			
Solution:	Demolish existing and construct curb cut			
Bar. Severity:	1 Necessary	Cost Estimate:	\$2,500.00	Status:
Implementation Priority:	2	Facility Function:		
Implementation Phase:		Implementation Date:		
Official Responsible:

Notes:	Two - way intersection. Corners B,C
--------	-------------------------------------

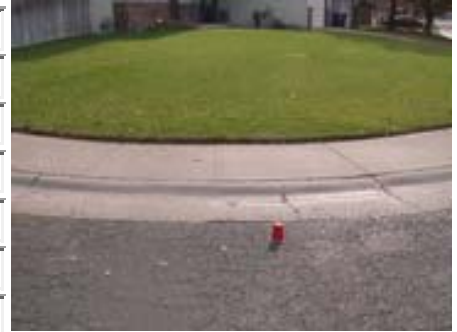
Barrier Type: No Curb Ramp

Code Ref: CBC 1127B.5.1 and ADA/ABA 402.2

As Built Meas: 1 Quantity: EACH

Description: No curb cut at corner (intersection)

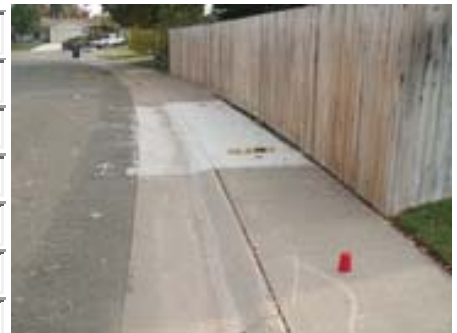
Barrier Type: Cross Slope - Existing (5.0% or more)

Code Ref: CBC 1133B.7.1.3 and ADA/ABA 403.3

As Built Meas: 265 Quantity: LF

Description: Cross slope exceeds 2.0% (5.0% or more)

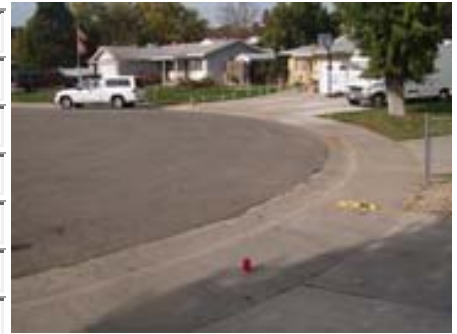
Barrier Type: Cross Slope - Existing (5.0% or more)

Code Ref: CBC 1133B.7.1.3 and ADA/ABA 403.3

As Built Meas: 263 Quantity: LF

Description: Cross slope exceeds 2.0% (5.0% or more)

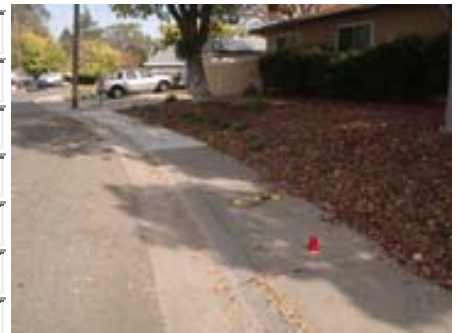
Barrier Type: Cross Slope - Existing (5.0% or more)

Code Ref: CBC 1133B.7.1.3 and ADA/ABA 403.3

As Built Meas: 266 Quantity: LF

Description: Cross slope exceeds 2.0% (5.0% or more)

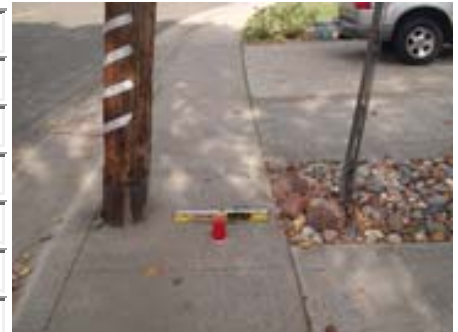
Barrier Type: Clear Width - Existing ($\leq 31"$ or less)

Code Ref: CBC 1133B.7.1

As Built Meas: 4 Quantity: LF

Description: Pedestrian route is not min. 48" wide ($\leq 31"$ or less)

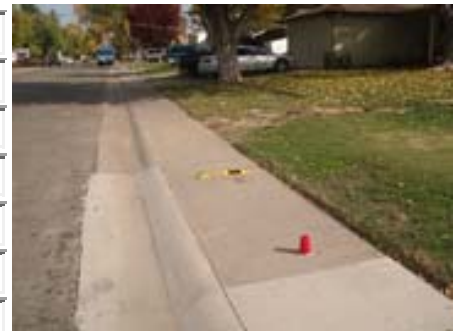
Barrier Type: Cross Slope - Existing (5.0% or more)

Code Ref: CBC 1133B.7.1.3 and ADA/ABA 403.3

As Built Meas: 1156 Quantity: LF

Description: Cross slope exceeds 2.0% (5.0% or more)

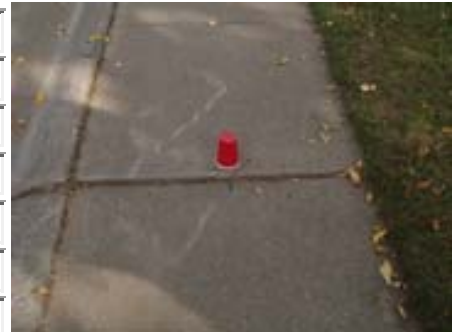
Barrier Type: Abrupt Change in Level - > 1/2"

Code Ref: CBC 1133B.7.1 and ADA/ABA 303.3

As Built Meas: 4 Quantity: LF

Description: Change in level greater than 1/2"

Solution: Grind or repair sidewalk to remove trip hazard

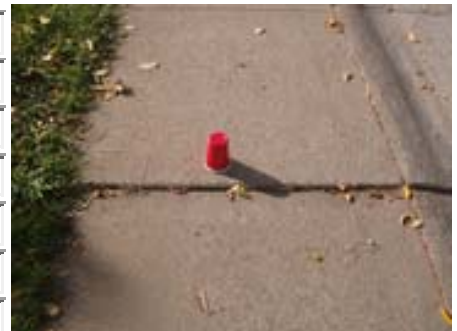
Barrier Type: Abrupt Change in Level - > 1/2"

Code Ref: CBC 1133B.7.1 and ADA/ABA 303.3

As Built Meas: 4 Quantity: LF

Description: Change in level greater than 1/2"

Solution: Grind or repair sidewalk to remove trip hazard

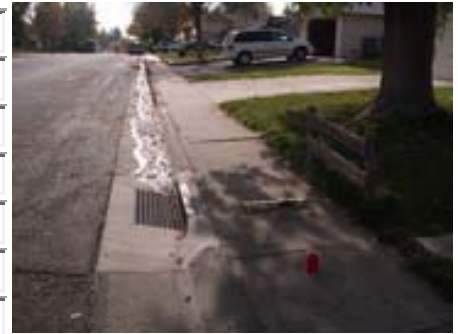
Barrier Type: Cross Slope - Existing (5.0% or more)

Code Ref: CBC 1133B.7.1.3 and ADA/ABA 403.3

As Built Meas: 546 Quantity: LF

Description: Cross slope exceeds 2.0% (5.0% or more)

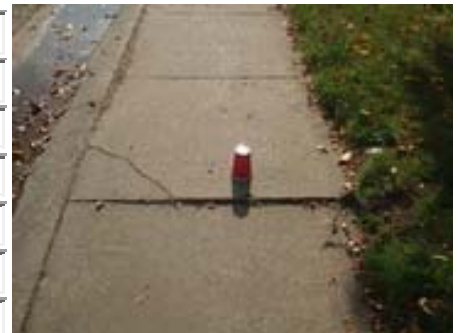
Barrier Type: Abrupt Change in Level - > 1/2"

Code Ref: CBC 1133B.7.1 and ADA/ABA 303.3

As Built Meas: 4 Quantity: LF

Description: Change in level greater than 1/2"

Solution: Grind or repair sidewalk to remove trip hazard

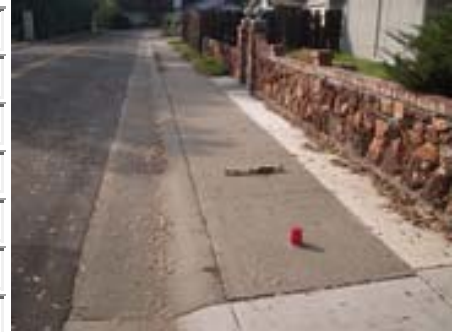
Barrier Type: Cross Slope - Existing (4.1% to 4.9%)

Code Ref: CBC 1133B.7.1.3 and ADA/ABA 403.3

As Built Meas: 222 Quantity: LF

Description: Cross slope exceeds 2.0% (4.1% to 4.9%)

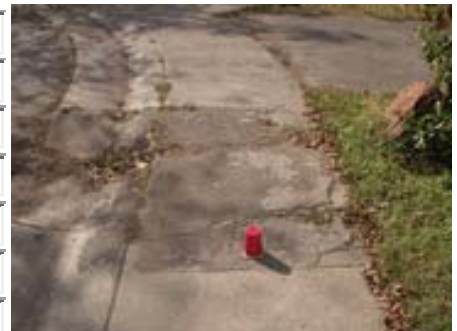
Barrier Type: Surface Condition - Damaged

Code Ref: CBC 1133B.7.1 and ADA/ABA 302.1

As Built Meas: 4 Quantity: LF

Description: Surface is not firm and stable (cracked, broken or loose soil, etc.)

As Built Desc: Cracked concrete

Solution: Repair surface to make firm and stable

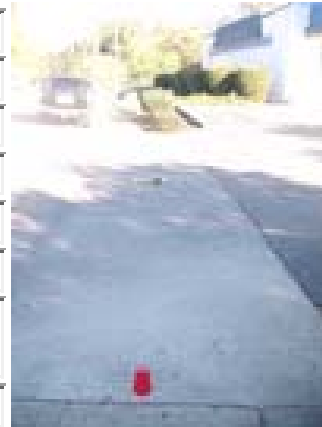
Barrier Type: Driveway - Existing (4.1% to 4.9%)

Code Ref: CBC 1133B.7.1.3 and ADA/ABA 403.3

As Built Meas: 37 Quantity: LF

Description: Driveway cross slope exceeds 2.0% (4.1% to 4.9%)

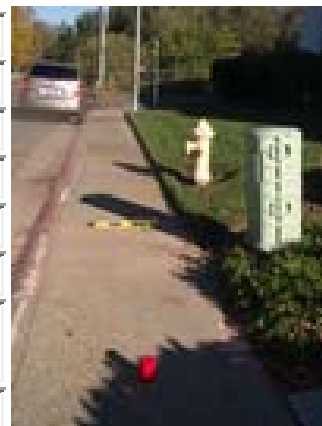
Barrier Type: Cross Slope - Existing (5.0% or more)

Code Ref: CBC 1133B.7.1.3 and ADA/ABA 403.3

As Built Meas: 54 Quantity: LF

Description: Cross slope exceeds 2.0% (5.0% or more)

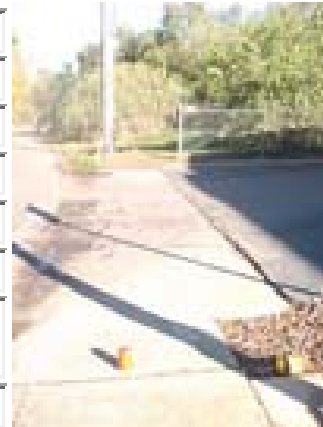
Barrier Type: Driveway - Existing (5.0% or more)

Code Ref: CBC 1133B.7.1.3 and ADA/ABA 403.3

As Built Meas: 39 Quantity: LF

Description: Driveway cross slope exceeds 2.0% (5.0% or more)

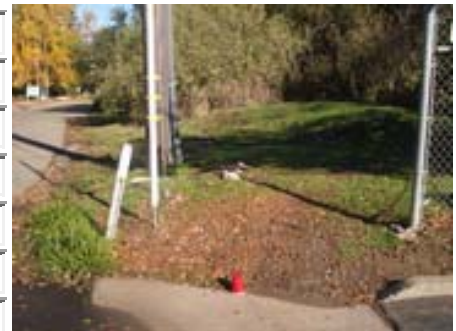
Barrier Type: No Sidewalk - No Barricade

Code Ref: MUTCD Section 6D.01

As Built Meas: 1 Quantity: JOB

Description: No barricade provided where sidewalk ends in hazardous location

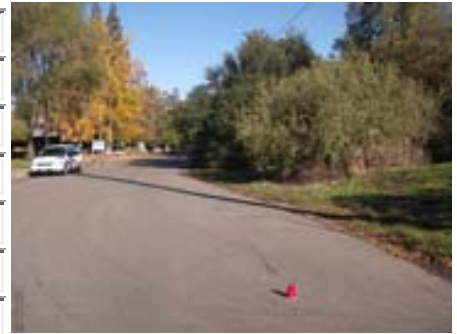
Barrier Type: Shoulder Cross Slope - Existing (5.0% or more)

Code Ref: CBC 1133B.7.1.3 and ADA/ABA 403.3

As Built Meas: 1231 Quantity: LF

Description: Cross slope exceeds 2.0% (5.0% or more)

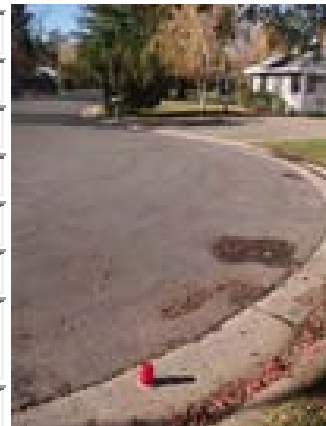
Barrier Type: Shoulder Cross Slope - Existing (3.1% to 4.0%)

Code Ref: CBC 1133B.7.1.3 and ADA/ABA 403.3

As Built Meas: 151 Quantity: LF

Description: Cross slope exceeds 2.0% (3.1% to 4.0%)

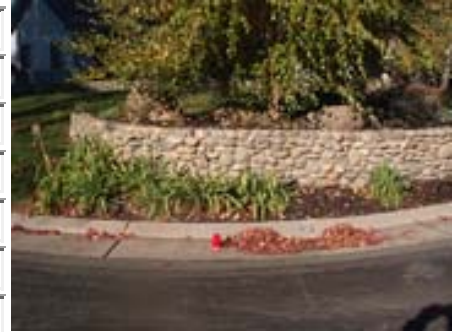
Barrier Type: No Curb Ramp

Code Ref: CBC 1127B.5.1 and ADA/ABA 402.2

As Built Meas: 1 Quantity: EACH

Description: No curb cut at corner (intersection)

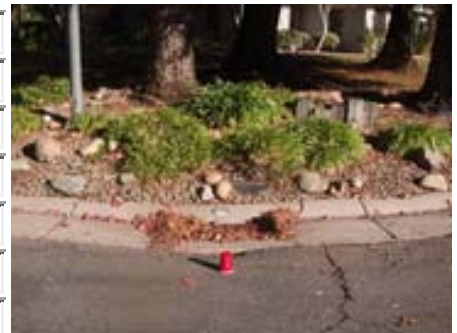
Barrier Type: No Curb Ramp

Code Ref: CBC 1127B.5.1 and ADA/ABA 402.2

As Built Meas: 1 Quantity: EACH

Description: No curb cut at corner (intersection)
