SZS CONSULTING GROUP

DRAFT ADA TRANSITION PLAN UPDATE
NEIGHBORHOOD AREA 3 CHANT
SEPTEMBER 20, 2011

CITY OF CITRUS HEIGHTS

Citrus Heights Area Three (CHANT)

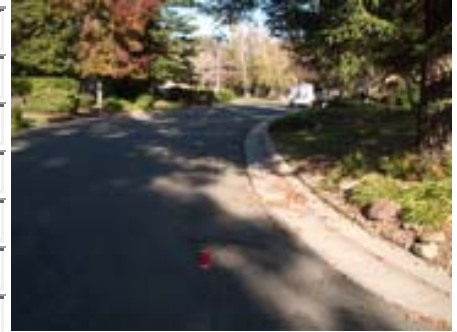
Field Date:	11/24/2010	Report Date:	11/24/2010	Barrier #:	2710
Location:	Mi Ct - East				
X Coordinate:	-121.32105				
Y Coordinate:	38.68401				
Barrier Area:	Sidewalks				
Barrier Type:	Shoulder Cross Slope - Existing (3.1% to 4.0%)				
Code Ref:	CBC 1133B.7.1.3 and ADA/ABA 403.3

As Built Meas:	260	Quantity:	LF	
Description:	Cross slope exceeds 2.0% (3.1% to 4.0%)			
As Built Desc:	3.2% cross slope			
Solution:	Demolish existing and construct new pedestrian route			
Bar. Severity:	3 Hindrance	Cost Estimate:	\$32,500.00	Status:
Implementation Priority:	4	Facility Function:		
Implementation Phase:		Implementation Date:		
Official Responsible:				
Notes:

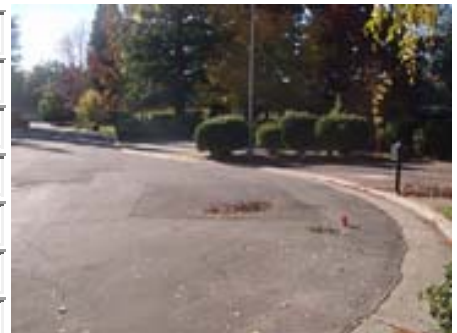
Field Date:	11/24/2010	Report Date:	11/24/2010	Barrier #:	2711
Location:	Mi Ct - West				
X Coordinate:	-121.32088				
Y Coordinate:	38.68362				
Barrier Area:	Sidewalks				
Barrier Type:	Shoulder Cross Slope - Existing (3.1% to 4.0%)				
Code Ref:	CBC 1133B.7.1.3 and ADA/ABA 403.3

As Built Meas:	240	Quantity:	LF	
Description:	Cross slope exceeds 2.0% (3.1% to 4.0%)			
As Built Desc:	3.6% cross slope			
Solution:	Demolish existing and construct new pedestrian route			
Bar. Severity:	3 Hindrance	Cost Estimate:	\$30,000.00	Status:
Implementation Priority:	4	Facility Function:		
Implementation Phase:		Implementation Date:		
Official Responsible:				
Notes:

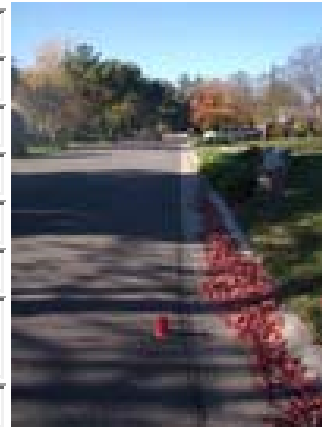
Barrier Type: Shoulder Cross Slope - Existing (5.0% or more)

Code Ref: CBC 1133B.7.1.3 and ADA/ABA 403.3

As Built Meas: 643 Quantity: LF

Description: Cross slope exceeds 2.0% (5.0% or more)

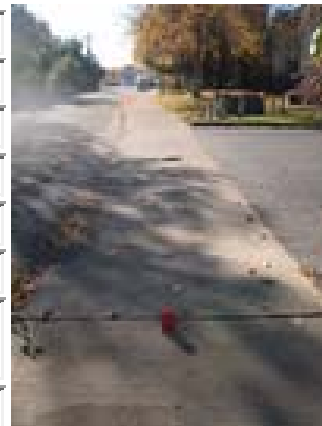
Barrier Type: Driveway - Existing (5.0% or more)

Code Ref: CBC 1133B.7.1.3 and ADA/ABA 403.3

As Built Meas: 43 Quantity: LF

Description: Driveway cross slope exceeds 2.0% (5.0% or more)

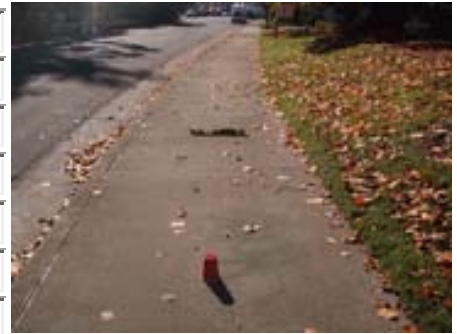
Barrier Type: Cross Slope - Existing (4.1% to 4.9%)

Code Ref: CBC 1133B.7.1.3 and ADA/ABA 403.3

As Built Meas: 74 Quantity: LF

Description: Cross slope exceeds 2.0% (4.1% to 4.9%)

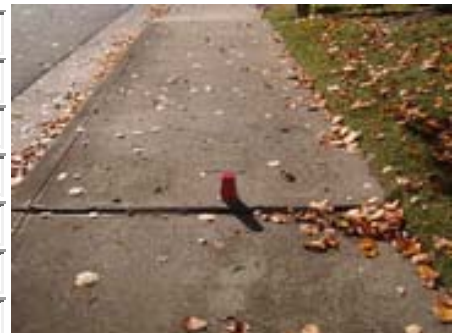
Barrier Type: Abrupt Change in Level - > 1/2"

Code Ref: CBC 1133B.7.1 and ADA/ABA 303.3

As Built Meas: 4 Quantity: LF

Description: Change in level greater than 1/2"

Solution: Grind or repair sidewalk to remove trip hazard

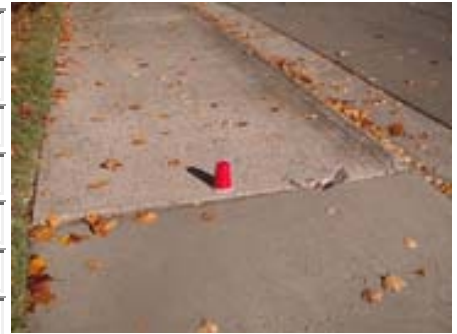
Barrier Type: Abrupt Change in Level - > 1/2"

Code Ref: CBC 1133B.7.1 and ADA/ABA 303.3

As Built Meas: 4 Quantity: LF

Description: Change in level greater than 1/2"

Solution: Grind or repair sidewalk to remove trip hazard

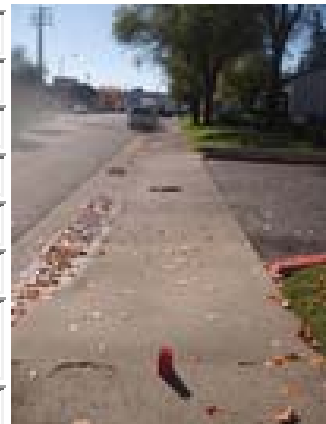
Barrier Type: Driveway - Existing (5.0% or more)

Code Ref: CBC 1133B.7.1.3 and ADA/ABA 403.3

As Built Meas: 43 Quantity: LF

Description: Driveway cross slope exceeds 2.0% (5.0% or more)

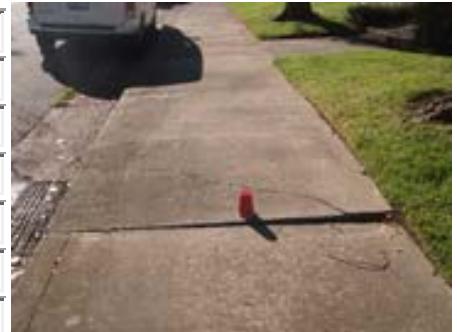
Barrier Type: Abrupt Change in Level - > 1/2"

Code Ref: CBC 1133B.7.1 and ADA/ABA 303.3

As Built Meas: 4 Quantity: LF

Description: Change in level greater than 1/2"

Solution: Grind or repair sidewalk to remove trip hazard

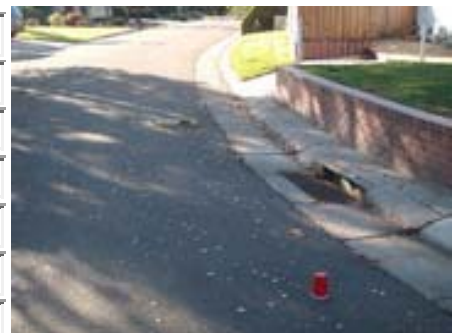
Barrier Type: Shoulder Cross Slope - Existing (5.0% or more)

Code Ref: CBC 1133B.7.1.3 and ADA/ABA 403.3

As Built Meas: 257 Quantity: LF

Description: Cross slope exceeds 2.0% (5.0% or more)

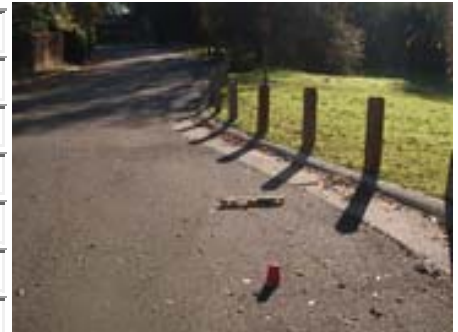
Barrier Type: Shoulder Cross Slope - Existing (5.0% or more)

Code Ref: CBC 1133B.7.1.3 and ADA/ABA 403.3

As Built Meas: 229 Quantity: LF

Description: Cross slope exceeds 2.0% (5.0% or more)

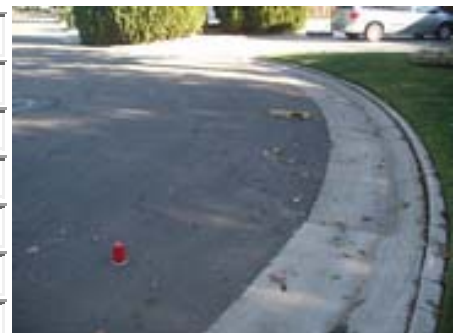
Barrier Type: Shoulder Cross Slope - Existing (5.0% or more)

Code Ref: CBC 1133B.7.1.3 and ADA/ABA 403.3

As Built Meas: 313 Quantity: LF

Description: Cross slope exceeds 2.0% (5.0% or more)

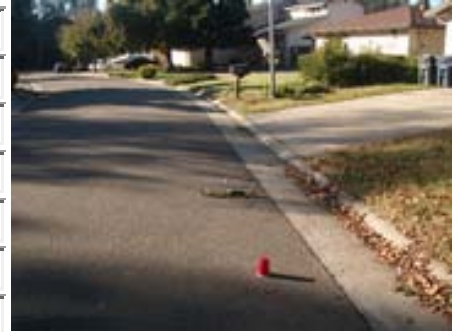
Field Date:	11/29/2010	Report Date:	11/29/2010	Barrier #:	2883
Location:	Tall Tree Cir - North				
X Coordinate:	-121.32471				
Y Coordinate:	38.68165				
Barrier Area:	Sidewalks				
Barrier Type:	Shoulder Cross Slope - Existing (5.0% or more)				
Code Ref:	CBC 1133B.7.1.3 and ADA/ABA 403.3

As Built Meas:	257	Quantity:	LF
Description:	Cross slope exceeds 2.0% (5.0% or more)		
As Built Desc:	5.5% cross slope		
Solution:	Demolish existing and construct new pedestrian route		
Bar. Severity:	1 Necessary	Cost Estimate:	\$32,125.00
Implementation Priority:	4	Facility Function:	
Implementation Phase:		Implementation Date:	
Official Responsible:			
Notes:

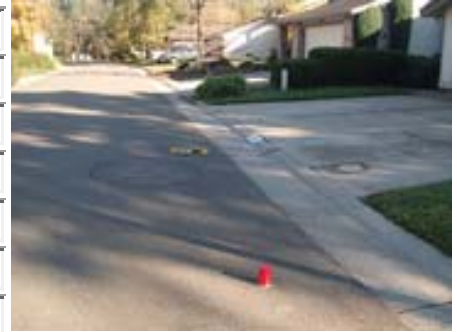
Barrier Type: Shoulder Cross Slope - Existing (5.0% or more)

Code Ref: CBC 1133B.7.1.3 and ADA/ABA 403.3

As Built Meas: 237 Quantity: LF

Description: Cross slope exceeds 2.0% (5.0% or more)

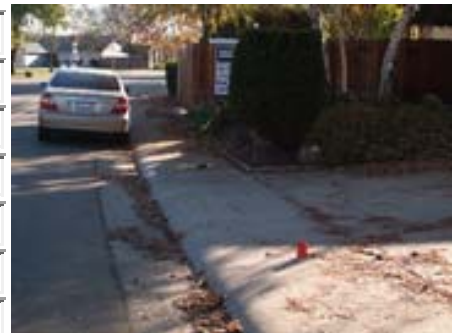
Barrier Type: Cross Slope - Existing (4.1% to 4.9%)

Code Ref: CBC 1133B.7.1.3 and ADA/ABA 403.3

As Built Meas: 203 Quantity: LF

Description: Cross slope exceeds 2.0% (4.1% to 4.9%)

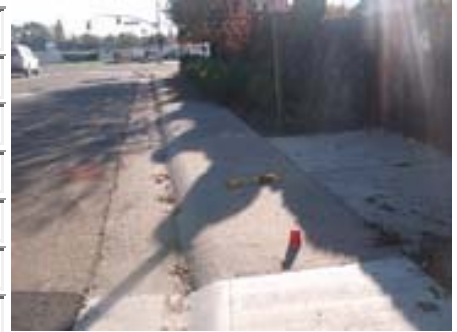
Barrier Type: Cross Slope - Existing (3.1% to 4.0%)

Code Ref: CBC 1133B.7.1.3 and ADA/ABA 403.3

As Built Meas: 95 Quantity: LF

Description: Cross slope exceeds 2.0% (3.1% to 4.0%)

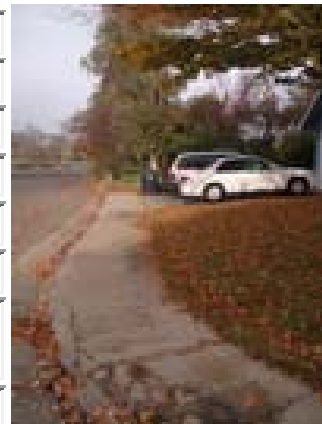
Barrier Type: No sidewalk (end of path)

Code Ref: CBC 1127B.1 and ADA/ABA 206.2.1

As Built Meas: 1 Quantity: JOB

Description: Sidewalk route ends and no opposite sidewalk exists

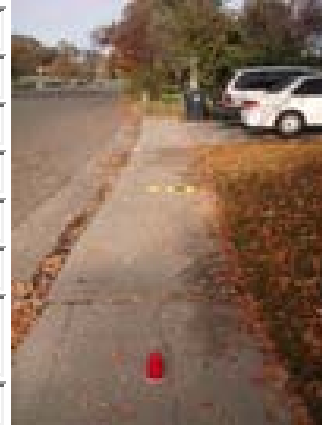
Barrier Type: Cross Slope - Existing (3.1% to 4.0%)

Code Ref: CBC 1133B.7.1.3 and ADA/ABA 403.3

As Built Meas: 58 Quantity: LF

Description: Cross slope exceeds 2.0% (3.1% to 4.0%)

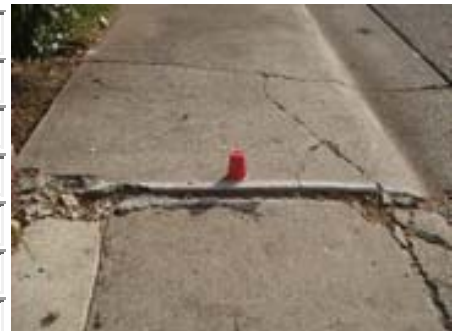
Barrier Type: Abrupt Change in Level - > 1/2"

Code Ref: CBC 1133B.7.1 and ADA/ABA 303.3

As Built Meas: 4 Quantity: LF

Description: Change in level greater than 1/2"

Solution: Grind or repair sidewalk to remove trip hazard

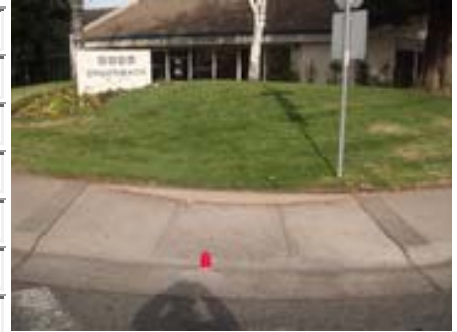
Barrier Type: Running Slope - Existing (9.5% or more)

Code Ref: CBC 1127B.5.3 and ADA/ABA 406.1

As Built Meas: 1 Quantity: EACH

Description: Ramp run cross slope exceeds 2.0% (9.5% or more)

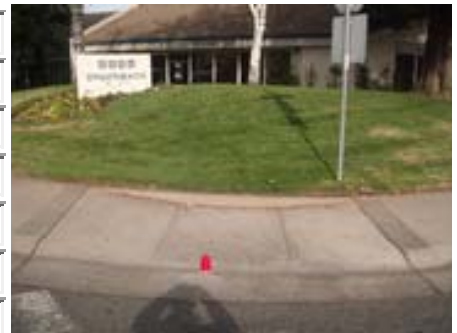
Barrier Type: Detectable Warnings - Truncated Domes

Code Ref: CBC 1127B.5.7 and ADA/ABA 705.1.3

As Built Meas: 1 Quantity: EACH

Description: No truncated domes provided at curb ramp

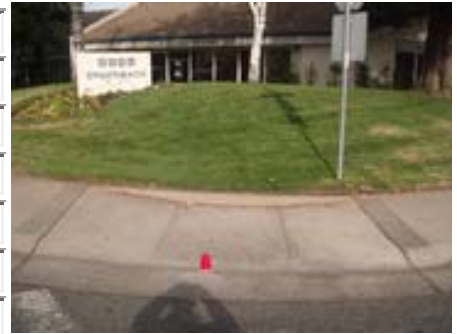
Barrier Type: Gutter Slope - Existing (8.3% or more)

Code Ref: CBC 1127B.5.3 and ADA/ABA 406.2

As Built Meas: 6 Quantity: SF

Description: Gutter slope exceeds 5.0% (8.3% or more)

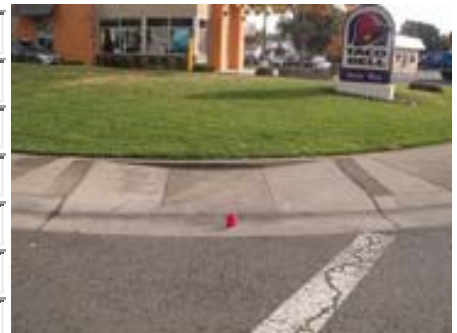
Barrier Type: 12" Grooves - Existing (3.1% to 4.0%)

Code Ref: CBC 1127B.5.6

As Built Meas: 1 Quantity: EACH

Description: 12" grooves at top of curb ramp are not level (3.1% to 4.0%)

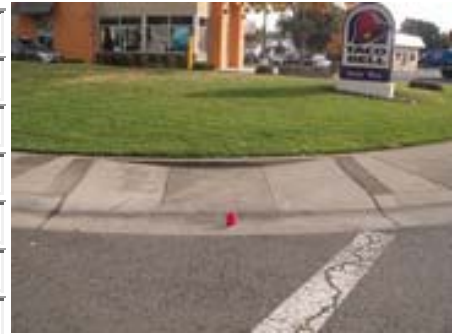
Barrier Type: Running Slope - Existing (9.0% to 9.4%)

Code Ref: CBC 1127B.5.3 and ADA/ABA 406.1

As Built Meas: 1 Quantity: EACH

Description: Ramp run cross slope exceeds 2.0% (9.0% to 9.4%)

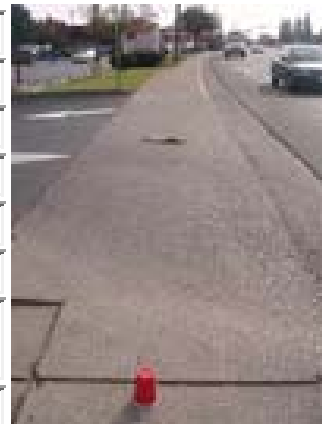
Barrier Type: Driveway - Existing (5.0% or more)

Code Ref: CBC 1133B.7.1.3 and ADA/ABA 403.3

As Built Meas: 35 Quantity: LF

Description: Driveway cross slope exceeds 2.0% (5.0% or more)

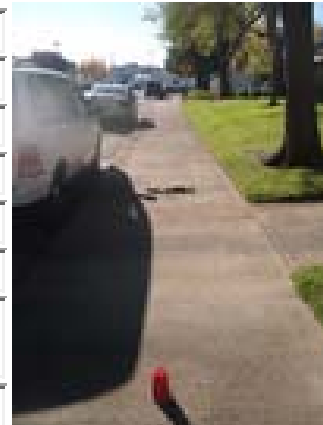
Barrier Type: Cross Slope - Existing (4.1% to 4.9%)

Code Ref: CBC 1133B.7.1.3 and ADA/ABA 403.3

As Built Meas: 115 Quantity: LF

Description: Cross slope exceeds 2.0% (4.1% to 4.9%)

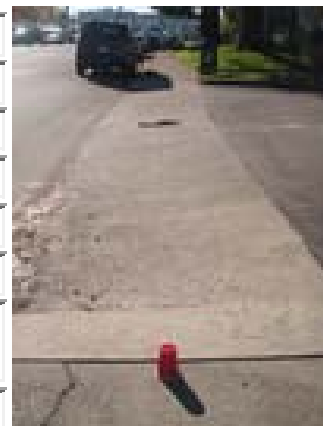
Barrier Type: Driveway - Existing (5.0% or more)

Code Ref: CBC 1133B.7.1.3 and ADA/ABA 403.3

As Built Meas: 39 Quantity: LF

Description: Driveway cross slope exceeds 2.0% (5.0% or more)

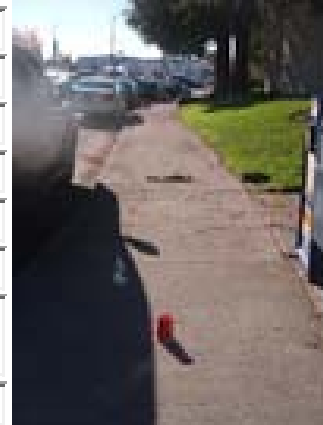
Barrier Type: Cross Slope - Existing (5.0% or more)

Code Ref: CBC 1133B.7.1.3 and ADA/ABA 403.3

As Built Meas: 172 Quantity: LF

Description: Cross slope exceeds 2.0% (5.0% or more)

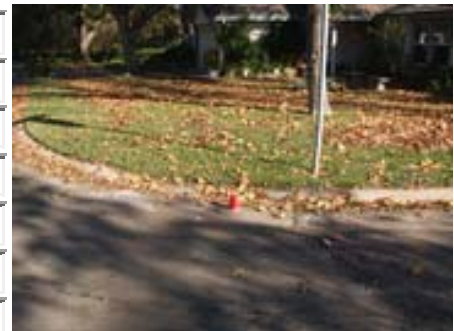
Location: Indian River Dr and Broken Arrow Ct - Corner B

Barrier Type: No Curb Ramp

Code Ref: CBC 1127B.5.1 and ADA/ABA 402.2

As Built Meas: 1 Quantity: EACH

Description: No curb cut at corner (intersection)

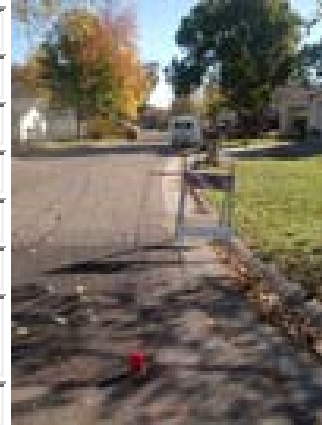
Location: Broken Arrow Ct - South

Barrier Type: Cross Slope - Existing (4.1% to 4.9%)

Code Ref: CBC 1133B.7.1.3 and ADA/ABA 403.3

As Built Meas: 329 Quantity: LF

Description: Cross slope exceeds 2.0% (4.1% to 4.9%)

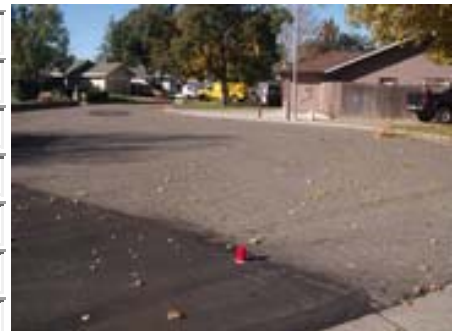
Barrier Type: Shoulder Cross Slope - Existing (3.1% to 4.0%)

Description: Cross slope exceeds 2.0% (3.1% to 4.0%)

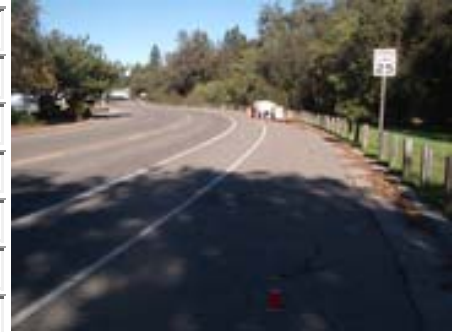
Field Date:	11/24/2010	Report Date:	11/24/2010	Barrier #:	2725
Location:	Indian River Dr - East				
X Coordinate:	-121.32457				
Y Coordinate:	38.68246				
Barrier Area:	Sidewalks				
Barrier Type:	No sidewalk				
Code Ref:	CBC 1127B.1 and ADA/ABA 206.2.1

As Built Meas:	739	Quantity:	LF
Description:	No pedestrian route provided		
As Built Desc:	No sidewalk provided		
Solution:	Construct new firm and stable pedestrian route		
Bar. Severity:	1 Necessary	Cost Estimate:	\$73,900.00
Implementation Priority:	2	Facility Function:	
Implementation Phase:		Implementation Date:	
Official Responsible:

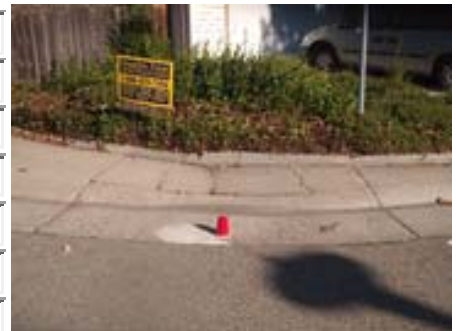
Field Date:	11/24/2010	Report Date:	11/24/2010	Barrier #:	2726
Location:	Indian River Dr and Little Arrow Ct - Corner B				
X Coordinate:	-121.32523				
Y Coordinate:	38.68367				
Barrier Area:	Curb Ramps				
Barrier Type:	No Curb Ramp				
Code Ref:	CBC 1127B.5.1 and ADA/ABA 402.2

As Built Meas:	1	Quantity:	EACH
Description:	No curb cut at corner (intersection)		
As Built Desc:	No curb ramp at corner		
Solution:	Demolish existing and construct curb cut		
Bar. Severity:	1 Necessary	Cost Estimate:	\$2,500.00
Implementation Priority:	2	Facility Function:	
Implementation Phase:		Implementation Date:	
Official Responsible:

Notes:	Four - way intersection. Corners A,B,C,D. Corners A,D compliant
--------	---

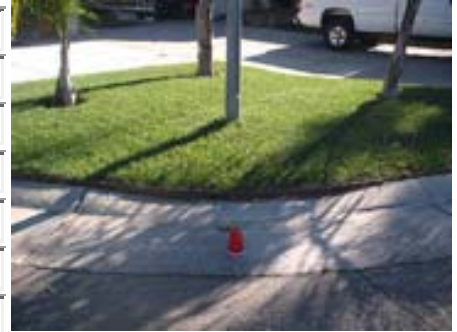
Barrier Type: No Curb Ramp

Description: No curb cut at corner (intersection)

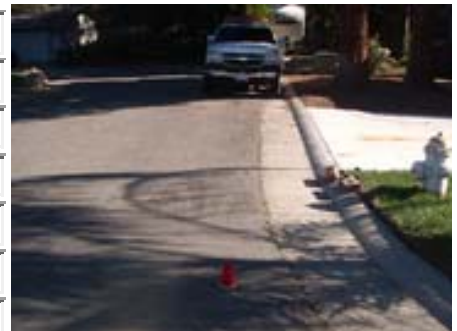
Barrier Type: Shoulder Cross Slope - Existing (3.1% to 4.0%)

Description: Cross slope exceeds 2.0% (3.1% to 4.0%)

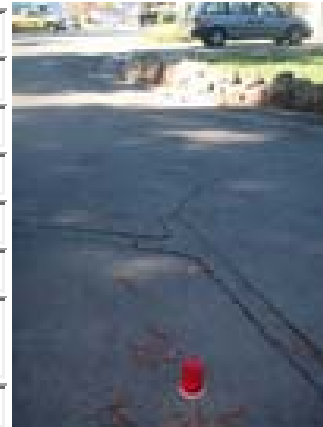
Barrier Type: Cross Slope - Existing (4.1% to 4.9%)

Description: Cross slope exceeds 2.0% (4.1% to 4.9%)

Bar. Severity: 2 Recommended Cost Estimate: \$11,625.00 Status:

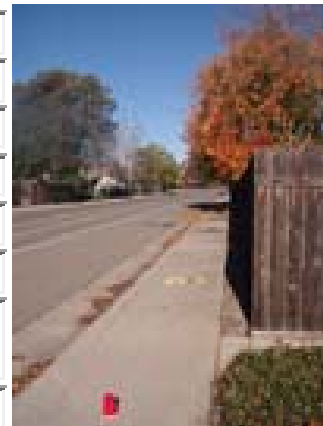
Barrier Type: Cross Slope - Existing (5.0% or more)

Description: Cross slope exceeds 2.0% (5.0% or more)

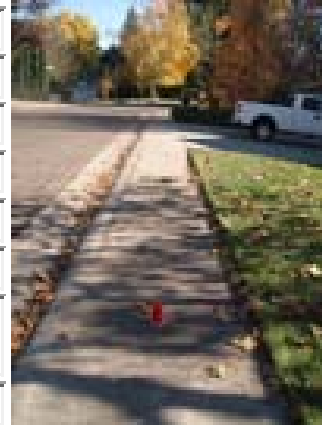
Location: Broken Bow Dr - South

Barrier Type: Cross Slope - Existing (3.1% to 4.0%)

Description: Cross slope exceeds 2.0% (3.1% to 4.0%)

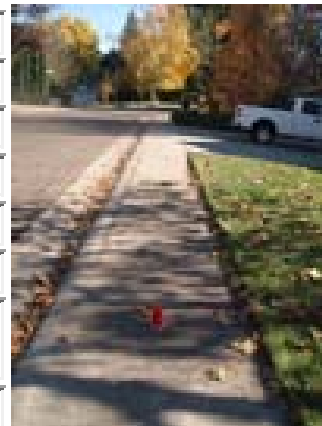
Location: Broken Bow Dr - West

Barrier Type: Cross Slope - Existing (3.1% to 4.0%)

Description: Cross slope exceeds 2.0% (3.1% to 4.0%)

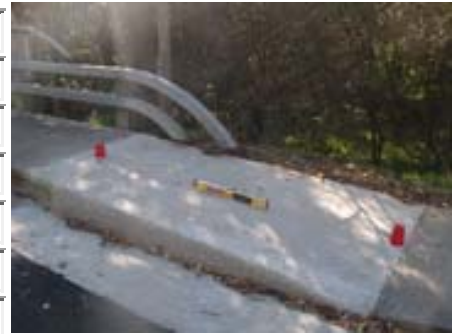
Location: Broken Bow Dr - West

Barrier Type: Running Slope (New Construction)

Description: Running slope exceeds 5.0% where roadway slope does not

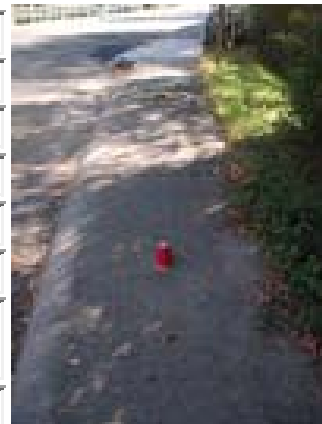
Location: Broken Bow Dr - West

Barrier Type: Cross Slope - Existing (3.1% to 4.0%)

Description: Cross slope exceeds 2.0% (3.1% to 4.0%)

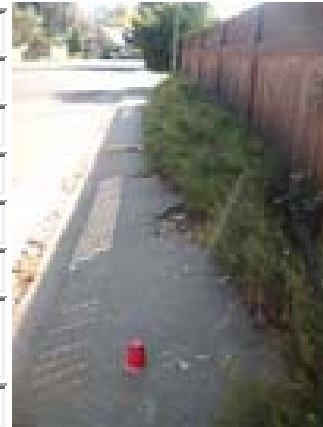
Location: Broken Bow Dr - West

Barrier Type: Clear Width - Existing ($\leq 31"$ or less)

Description: Pedestrian route is not min. 48" wide ($\leq 31"$ or less)

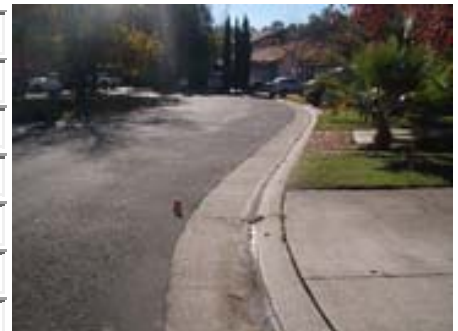
Barrier Type: Shoulder Cross Slope - Existing (3.1% to 4.0%)

Description: Cross slope exceeds 2.0% (3.1% to 4.0%)

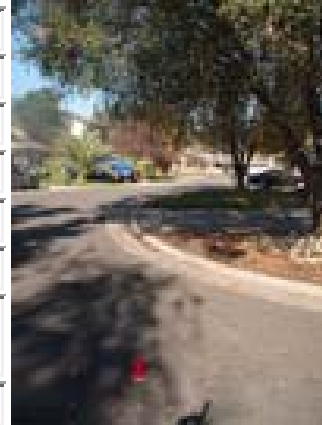
Barrier Type: Shoulder Cross Slope - Existing (3.1% to 4.0%)

Description: Cross slope exceeds 2.0% (3.1% to 4.0%)

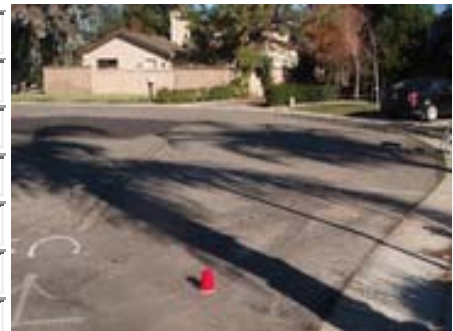
Location: Broken Bow Dr - East

Barrier Type: Cross Slope - Existing (4.1% to 4.9%)

Description: Cross slope exceeds 2.0% (4.1% to 4.9%)

Bar. Severity: 2 Recommended Cost Estimate: \$14,625.00 Status:

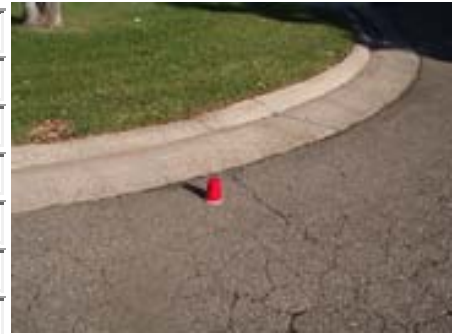
Location: Broken Bow Dr and Sudden Wind Ct - Corner B

Barrier Type: No Curb Ramp

Description: No curb cut at corner (intersection)

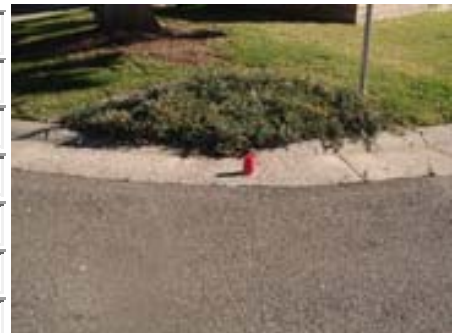
Location: Broken Bow Dr and Sudden Wind Ct - Corner D

Barrier Type: No Curb Ramp

Description: No curb cut at corner (intersection)

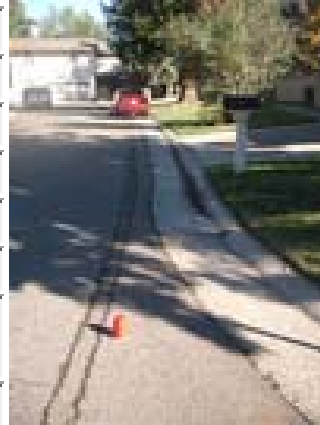
Barrier Type: Shoulder Cross Slope - Existing (4.1% to 4.9%)

Description: Cross slope exceeds 2.0% (4.1% to 4.9%)

Bar. Severity: 2 Recommended

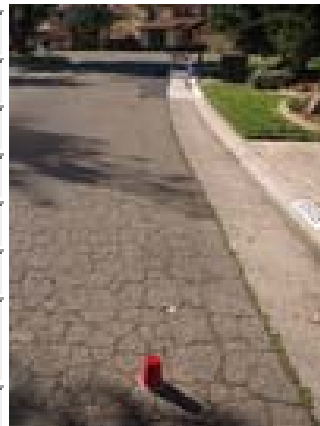
Barrier Type: Shoulder Cross Slope - Existing (3.1% to 4.0%)

Description: Cross slope exceeds 2.0% (3.1% to 4.0%)

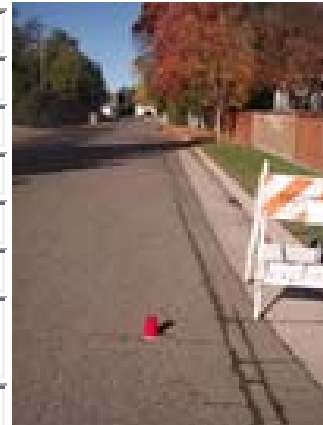
Location: Broken Bow Dr - East

Barrier Type: Shoulder Cross Slope - Existing (3.1% to 4.0%)

Description: Cross slope exceeds 2.0% (3.1% to 4.0%)

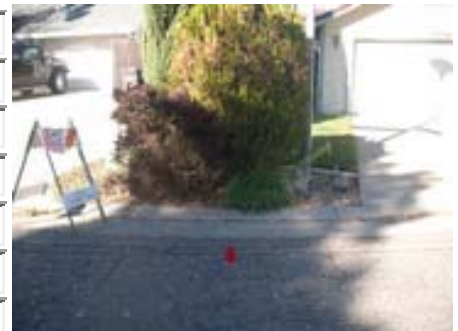
Location: Broken Bow Dr and Fast Water Ct - Corner A

Barrier Type: No Curb Ramp

Description: No curb cut at corner (intersection)

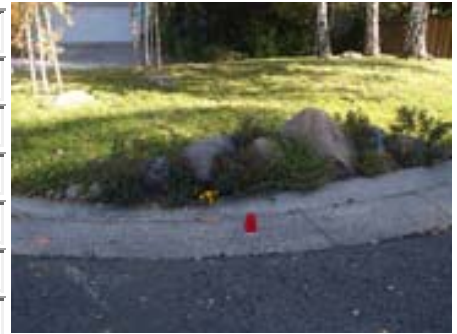
Location: Broken Bow Dr and Fast Water Ct - Corner B

Barrier Type: No Curb Ramp

Description: No curb cut at corner (intersection)

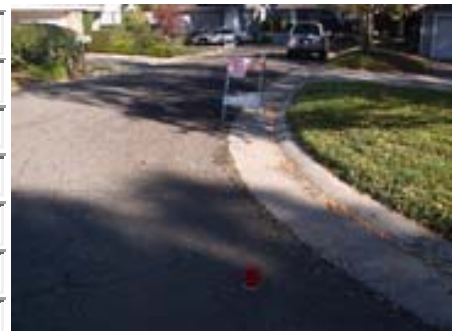
Barrier Type: Shoulder Cross Slope - Existing (3.1% to 4.0%)

Description: Cross slope exceeds 2.0% (3.1% to 4.0%)

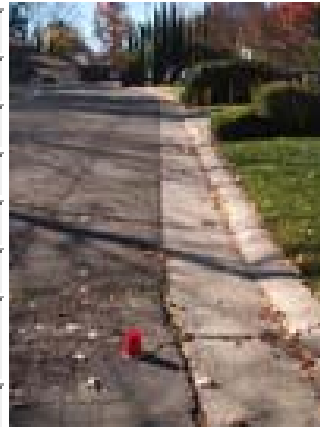
Barrier Type: Shoulder Cross Slope - Existing (4.1% to 4.9%)

Description: Cross slope exceeds 2.0% (4.1% to 4.9%)

Bar. Severity: 2 Recommended Cost Estimate: \$13,375.00 Status:

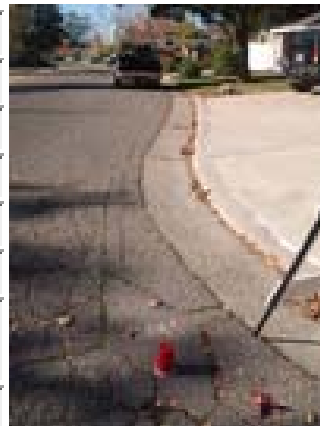
Location: Broken Bow Dr - North

Barrier Type: Shoulder Cross Slope - Existing (3.1% to 4.0%)

Description: Cross slope exceeds 2.0% (3.1% to 4.0%)

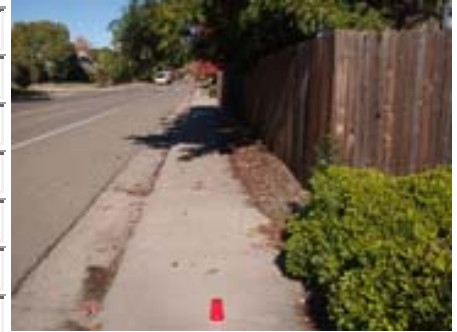
Barrier Type: Cross Slope - Existing (4.1% to 4.9%)

Description: Cross slope exceeds 2.0% (4.1% to 4.9%)

Bar. Severity: 2 Recommended Cost Estimate: \$19,500.00 Status:

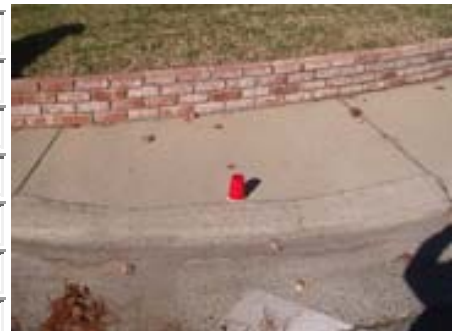
Barrier Type: No Curb Ramp - Depressed Existing Curb

Description: No compliant curb cut at corner (intersection)

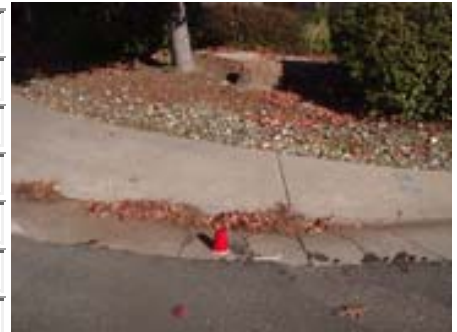
Barrier Type: No Curb Ramp - Depressed Existing Curb

Description: No compliant curb cut at corner (intersection)

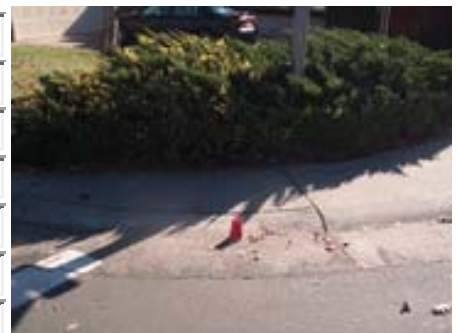
Barrier Type: No Curb Ramp - Depressed Existing Curb

Description: No compliant curb cut at corner (intersection)

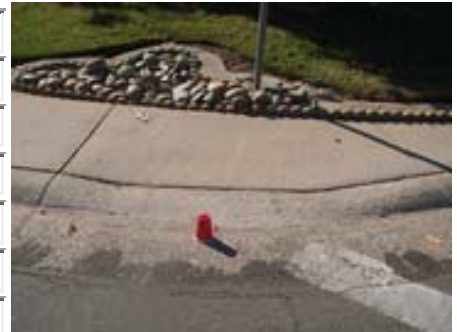
Barrier Type: No Curb Ramp - Depressed Existing Curb

Description: No compliant curb cut at corner (intersection)

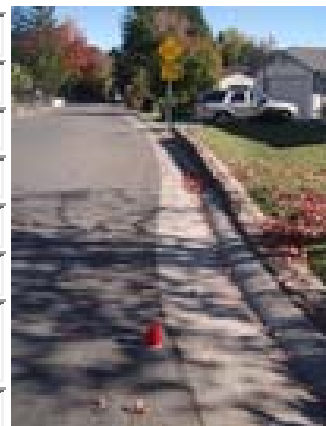
Barrier Type: No sidewalk

Description: No pedestrian route provided

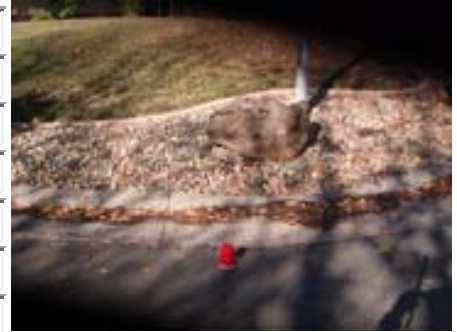
Barrier Type: No Curb Ramp

Description: No curb cut at corner (intersection)

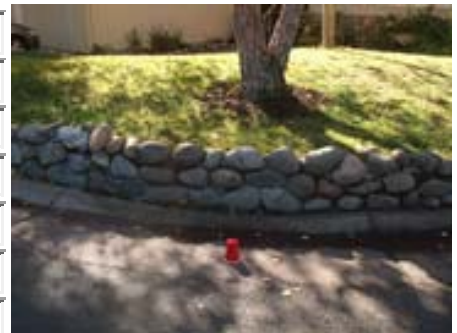
Barrier Type: No Curb Ramp

Description: No curb cut at corner (intersection)

Notes: Two - way intersection. Corners A,D

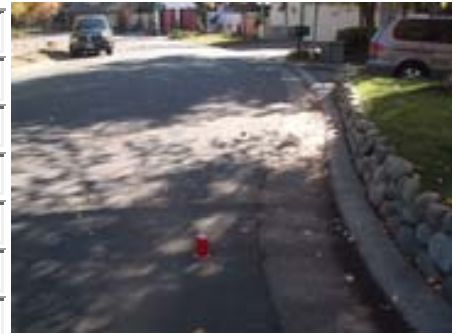
Field Date:	11/24/2010	Report Date:	11/24/2010	Barrier #:	2755
Location:	Shadow Hawk - South				
X Coordinate:	-121.32245				
Y Coordinate:	38.68482				
Barrier Area:	Sidewalks				
Barrier Type:	Shoulder Cross Slope - Existing (3.1% to 4.0%)				
Code Ref:	CBC 1133B.7.1.3 and ADA/ABA 403.3

As Built Meas:	1032	Quantity:	LF
Description:	Cross slope exceeds 2.0% (3.1% to 4.0%)		
As Built Desc:	3.1% cross slope		
Solution:	Demolish existing and construct new pedestrian route		
Bar. Severity:	3 Hindrance	Cost Estimate:	\$129,000.00
Implementation Priority:	4	Facility Function:	
Implementation Phase:		Implementation Date:	
Official Responsible:			
Notes:

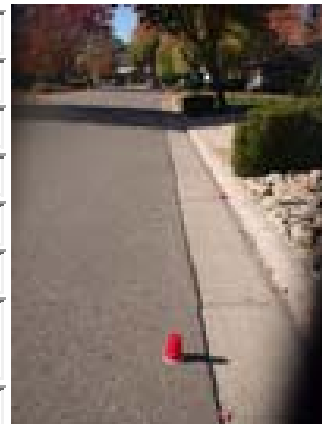
Field Date:	11/24/2010	Report Date:	11/24/2010	Barrier #:	2756
Location:	Shadow Hawk - North				
X Coordinate:	-121.32019				
Y Coordinate:	38.68512				
Barrier Area:	Sidewalks				
Barrier Type:	Shoulder Cross Slope - Existing (3.1% to 4.0%)				
Code Ref:	CBC 1133B.7.1.3 and ADA/ABA 403.3

As Built Meas:	1028	Quantity:	LF
Description:	Cross slope exceeds 2.0% (3.1% to 4.0%)		
As Built Desc:	3.3% cross slope		
Solution:	Demolish existing and construct new pedestrian route		
Bar. Severity:	3 Hindrance	Cost Estimate:	\$128,500.00
Implementation Priority:	4	Facility Function:	
Implementation Phase:		Implementation Date:	
Official Responsible:			
Notes:

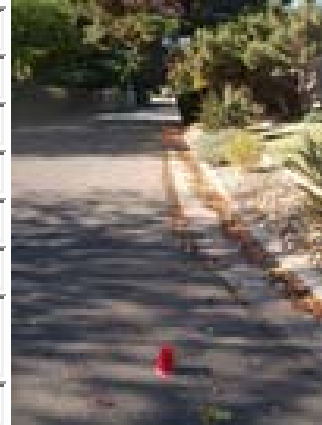
Barrier Type: Cross Slope - Existing (3.1% to 4.0%)

Description: Cross slope exceeds 2.0% (3.1% to 4.0%)

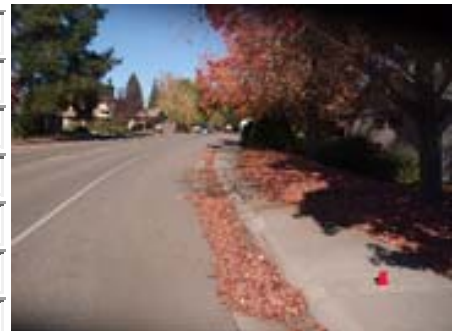
Barrier Type: No sidewalk

Description: No pedestrian route provided

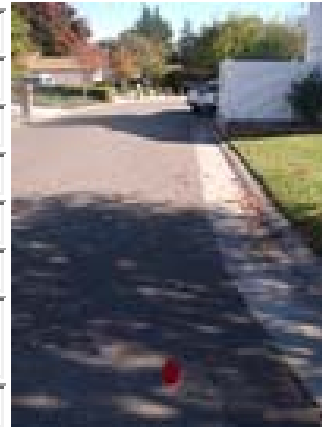
Barrier Type: Shoulder Cross Slope - Existing (3.1% to 4.0%)

Description: Cross slope exceeds 2.0% (3.1% to 4.0%)

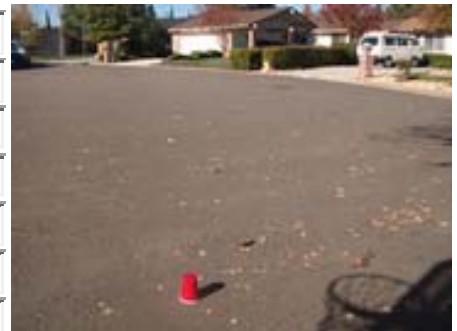
Barrier Type: Cross Slope - Existing (3.1% to 4.0%)

Description: Cross slope exceeds 2.0% (3.1% to 4.0%)

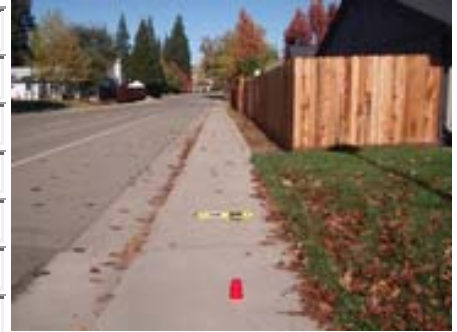
Barrier Type: Cross Slope - Existing (5.0% or more)

Description: Cross slope exceeds 2.0% (5.0% or more)

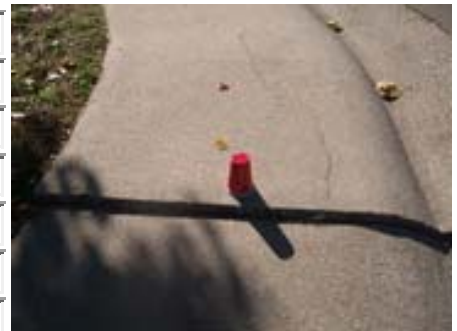
Barrier Type: Abrupt Change in Level - > 1/2"

Code Ref: CBC 1133B.7.1 and ADA/ABA 303.3

As Built Meas: 4 Quantity: LF

Description: Change in level greater than 1/2"

Solution: Grind or repair sidewalk to remove trip hazard

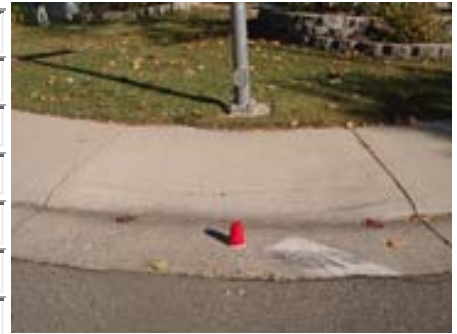
Field Date:	11/24/2010	Report Date:	11/24/2010	Barrier #:	2764
Location:	Indian River Dr and Flaming Arrow Dr - Corner B				
X Coordinate:	-121.32556				
Y Coordinate:	38.68662				
Barrier Area:	Curb Ramps				
Barrier Type:	No Curb Ramp - Depressed Existing Curb				
Code Ref:	CBC 1127B.5.1 and ADA/ABA 402.2

As Built Meas:	1	Quantity:	EACH	
Description:	No compliant curb cut at corner (intersection)			
As Built Desc:	12.8% running slope at depressed area			
Solution:	Demolish existing and construct curb cut			
Bar. Severity:	1 Necessary	Cost Estimate:	\$2,500.00	Status:
Implementation Priority:	2	Facility Function:		
Implementation Phase:		Implementation Date:		
Official Responsible:				
Notes:	Two - way intersection corners B,C

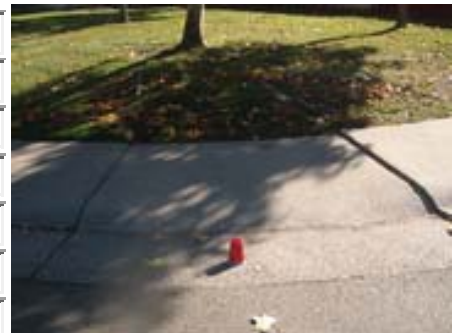
Field Date:	11/24/2010	Report Date:	11/24/2010	Barrier #:	2765
Location:	Indian River Dr and Flaming Arrow Dr - Corner C				
X Coordinate:	-121.32555				
Y Coordinate:	38.68656				
Barrier Area:	Curb Ramps				
Barrier Type:	No Curb Ramp - Depressed Existing Curb				
Code Ref:	CBC 1127B.5.1 and ADA/ABA 402.2

As Built Meas:	1	Quantity:	EACH	
Description:	No compliant curb cut at corner (intersection)			
As Built Desc:	11.0% running slope at depressed area			
Solution:	Demolish existing and construct curb cut			
Bar. Severity:	1 Necessary	Cost Estimate:	\$2,500.00	Status:
Implementation Priority:	2	Facility Function:		
Implementation Phase:		Implementation Date:		
Official Responsible:				
Notes:	Two - way intersection corners B,C

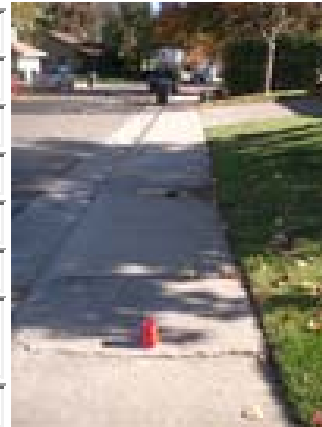
Barrier Type: Cross Slope - Existing (4.1% to 4.9%)

Code Ref: CBC 1133B.7.1.3 and ADA/ABA 403.3

As Built Meas: 618 Quantity: LF

Description: Cross slope exceeds 2.0% (4.1% to 4.9%)

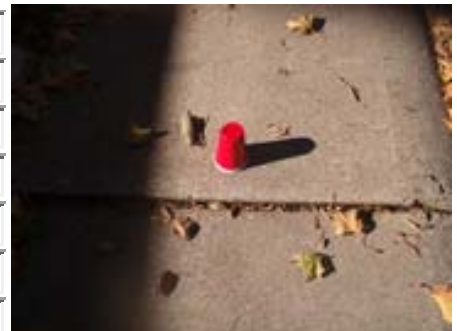
Barrier Type: Abrupt Change in Level - > 1/2"

Code Ref: CBC 1133B.7.1 and ADA/ABA 303.3

As Built Meas: 4 Quantity: LF

Description: Change in level greater than 1/2"

Solution: Grind or repair sidewalk to remove trip hazard

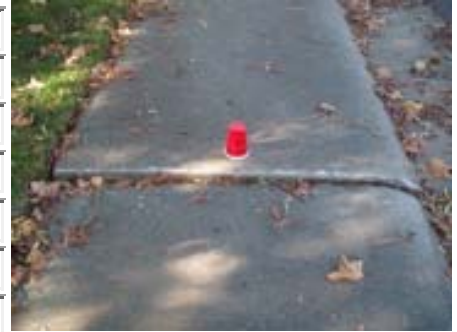
Barrier Type: Abrupt Change in Level - > 1/2"

Code Ref: CBC 1133B.7.1 and ADA/ABA 303.3

As Built Meas: 4 Quantity: LF

Description: Change in level greater than 1/2"

Solution: Grind or repair sidewalk to remove trip hazard

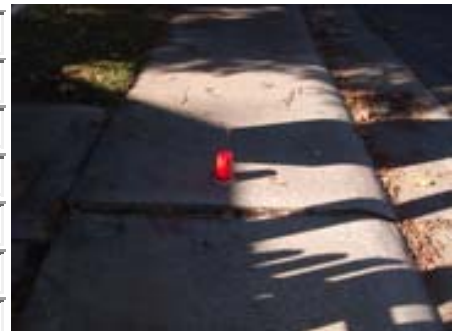
Barrier Type: Abrupt Change in Level - > 1/2"

Code Ref: CBC 1133B.7.1 and ADA/ABA 303.3

As Built Meas: 4 Quantity: LF

Description: Change in level greater than 1/2"

Solution: Grind or repair sidewalk to remove trip hazard

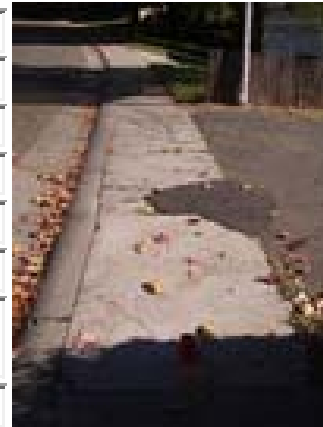
Barrier Type: Surface Condition - Damaged

Code Ref: CBC 1133B.7.1 and ADA/ABA 302.1

As Built Meas: 20 Quantity: LF

Description: Surface is not firm and stable (cracked, broken or loose soil, etc.)

As Built Desc: Cracked concrete

Solution: Repair surface to make firm and stable

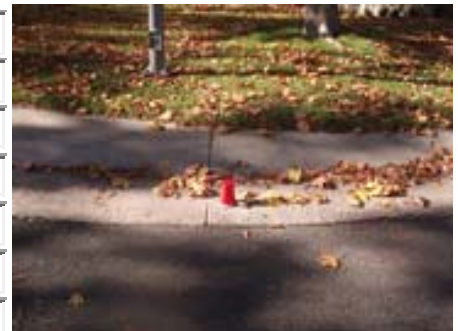
Barrier Type: No Curb Ramp

Code Ref: CBC 1127B.5.1 and ADA/ABA 402.2

As Built Meas: 1 Quantity: EACH

Description: No curb cut at corner (intersection)

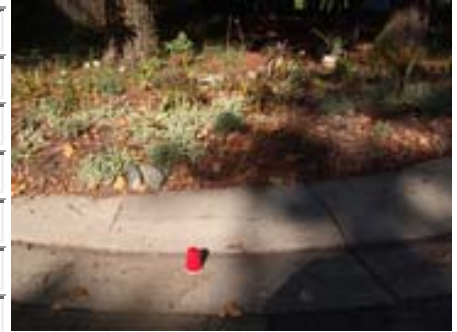
Barrier Type: No Curb Ramp - Depressed Existing Curb

Code Ref: CBC 1127B.5.1 and ADA/ABA 402.2

As Built Meas: 1 Quantity: EACH

Description: No compliant curb cut at corner (intersection)

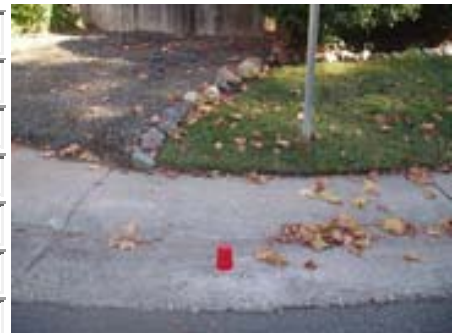
Barrier Type: No Curb Ramp

Code Ref: CBC 1127B.5.1 and ADA/ABA 402.2

As Built Meas: 1 Quantity: EACH

Description: No curb cut at corner (intersection)

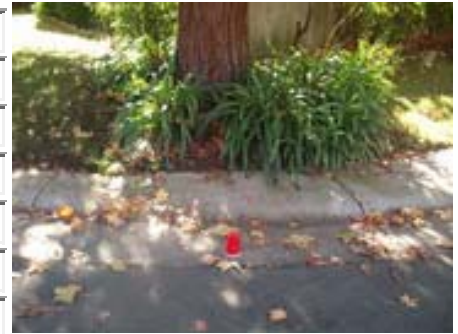
Barrier Type: No Curb Ramp

Code Ref: CBC 1127B.5.1 and ADA/ABA 402.2

As Built Meas: 1 Quantity: EACH

Description: No curb cut at corner (intersection)

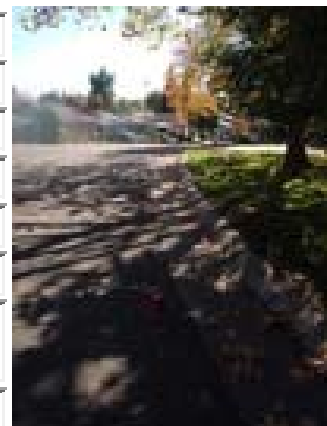
Barrier Type: Shoulder Cross Slope - Existing (5.0% or more)

Code Ref: CBC 1133B.7.1.3 and ADA/ABA 403.3

As Built Meas: 490 Quantity: LF

Description: Cross slope exceeds 2.0% (5.0% or more)

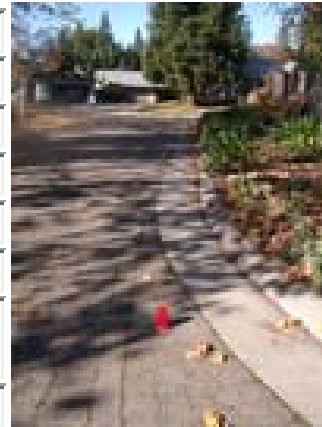
Barrier Type: Shoulder Cross Slope - Existing (5.0% or more)

Code Ref: CBC 1133B.7.1.3 and ADA/ABA 403.3

As Built Meas: 510 Quantity: LF

Description: Cross slope exceeds 2.0% (5.0% or more)

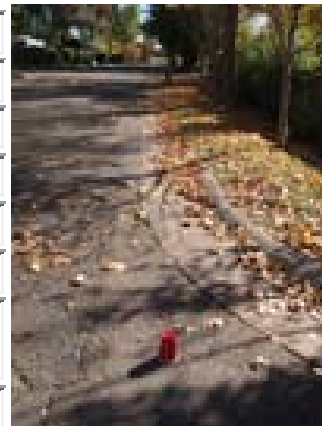
Barrier Type: Shoulder Cross Slope - Existing (4.1% to 4.9%)

Code Ref: CBC 1133B.7.1.3 and ADA/ABA 403.3

As Built Meas: 106 Quantity: LF

Description: Cross slope exceeds 2.0% (4.1% to 4.9%)

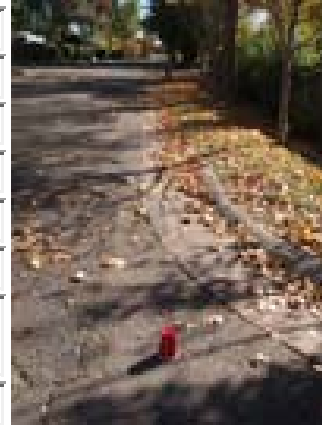
Barrier Type: Shoulder Cross Slope - Existing (5.0% or more)

Code Ref: CBC 1133B.7.1.3 and ADA/ABA 403.3

As Built Meas: 104 Quantity: LF

Description: Cross slope exceeds 2.0% (5.0% or more)

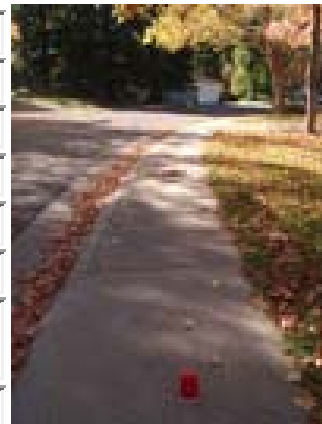
Barrier Type: Cross Slope - Existing (4.1% to 4.9%)

Code Ref: CBC 1133B.7.1.3 and ADA/ABA 403.3

As Built Meas: 604 Quantity: LF

Description: Cross slope exceeds 2.0% (4.1% to 4.9%)

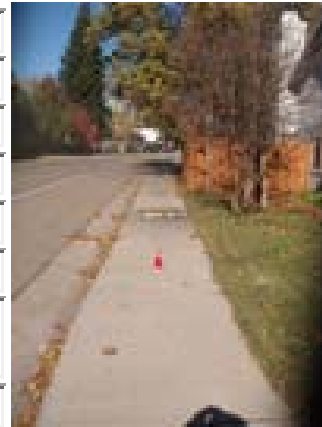
Barrier Type: Cross Slope - Existing (5.0% or more)

Code Ref: CBC 1133B.7.1.3 and ADA/ABA 403.3

As Built Meas: 295 Quantity: LF

Description: Cross slope exceeds 2.0% (5.0% or more)

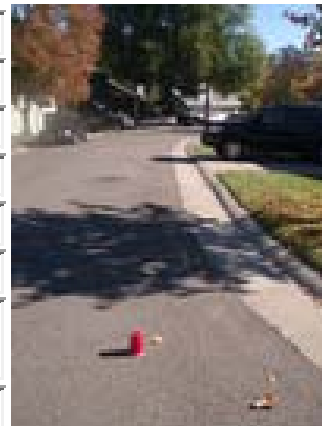
Barrier Type: Shoulder Cross Slope - Existing (3.1% to 4.0%)

Code Ref: CBC 1133B.7.1.3 and ADA/ABA 403.3

As Built Meas: 178 Quantity: LF

Description: Cross slope exceeds 2.0% (3.1% to 4.0%)

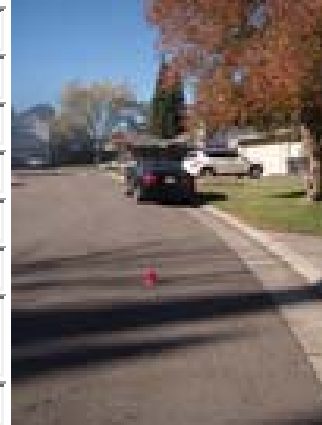
Barrier Type: Shoulder Cross Slope - Existing (3.1% to 4.0%)

Code Ref: CBC 1133B.7.1.3 and ADA/ABA 403.3

As Built Meas: 170 Quantity: LF

Description: Cross slope exceeds 2.0% (3.1% to 4.0%)

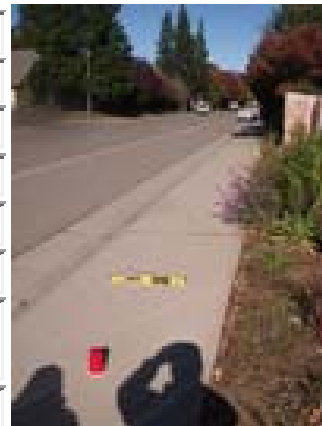
Barrier Type: Cross Slope - Existing (4.1% to 4.9%)

Code Ref: CBC 1133B.7.1.3 and ADA/ABA 403.3

As Built Meas: 604 Quantity: LF

Description: Cross slope exceeds 2.0% (4.1% to 4.9%)

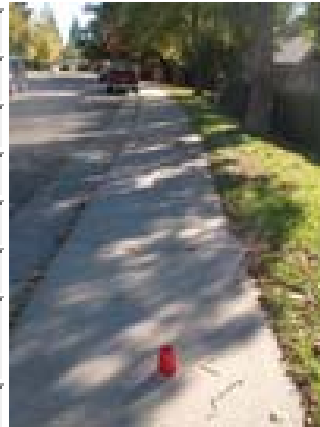
Barrier Type: Cross Slope - Existing (5.0% or more)

Code Ref: CBC 1133B.7.1.3 and ADA/ABA 403.3

As Built Meas: 721 Quantity: LF

Description: Cross slope exceeds 2.0% (5.0% or more)

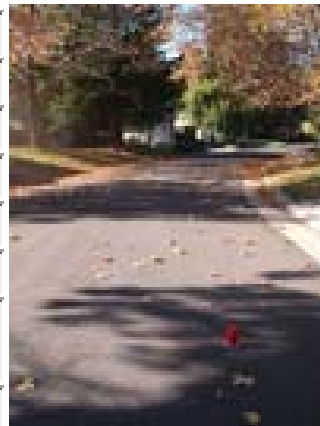
Barrier Type: Shoulder Cross Slope - Existing (5.0% or more)

Code Ref: CBC 1133B.7.1.3 and ADA/ABA 403.3

As Built Meas: 269 Quantity: LF

Description: Cross slope exceeds 2.0% (5.0% or more)

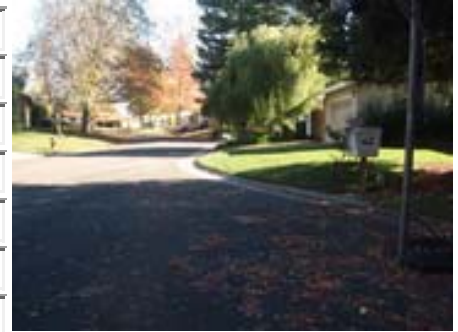
Barrier Type: Shoulder Cross Slope - Existing (3.1% to 4.0%)

Code Ref: CBC 1133B.7.1.3 and ADA/ABA 403.3

As Built Meas: 272 Quantity: LF

Description: Cross slope exceeds 2.0% (3.1% to 4.0%)

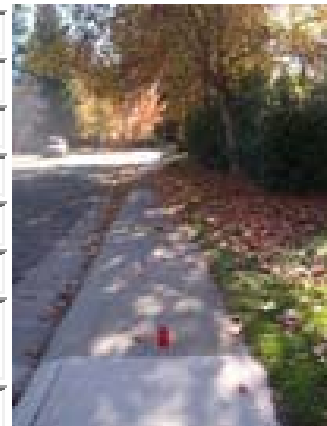
Barrier Type: Cross Slope - Existing (3.1% to 4.0%)

Code Ref: CBC 1133B.7.1.3 and ADA/ABA 403.3

As Built Meas: 258 Quantity: LF

Description: Cross slope exceeds 2.0% (3.1% to 4.0%)

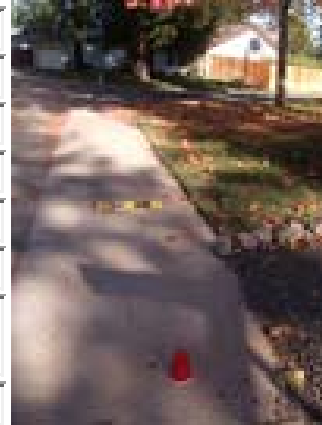
Barrier Type: Cross Slope - Existing (3.1% to 4.0%)

Code Ref: CBC 1133B.7.1.3 and ADA/ABA 403.3

As Built Meas: 30 Quantity: LF

Description: Cross slope exceeds 2.0% (3.1% to 4.0%)

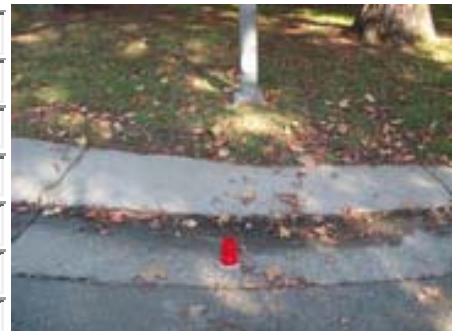
Barrier Type: No Curb Ramp

Code Ref: CBC 1127B.5.1 and ADA/ABA 402.2

As Built Meas: 1 Quantity: EACH

Description: No curb cut at corner (intersection)

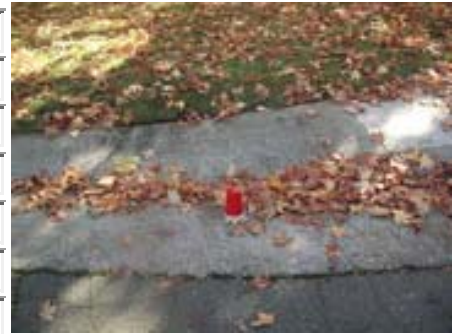
Barrier Type: No Curb Ramp

Code Ref: CBC 1127B.5.1 and ADA/ABA 402.2

As Built Meas: 1 Quantity: EACH

Description: No curb cut at corner (intersection)

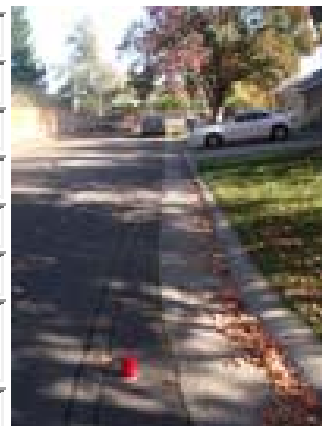
Barrier Type: Shoulder Cross Slope - Existing (4.1% to 4.9%)

Code Ref: CBC 1133B.7.1.3 and ADA/ABA 403.3

As Built Meas: 121 Quantity: LF

Description: Cross slope exceeds 2.0% (4.1% to 4.9%)

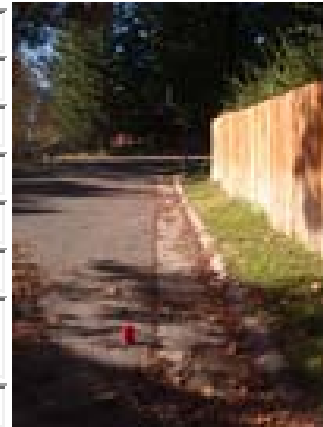
Barrier Type: Shoulder Cross Slope - Existing (3.1% to 4.0%)

Code Ref: CBC 1133B.7.1.3 and ADA/ABA 403.3

As Built Meas: 119 Quantity: LF

Description: Cross slope exceeds 2.0% (3.1% to 4.0%)

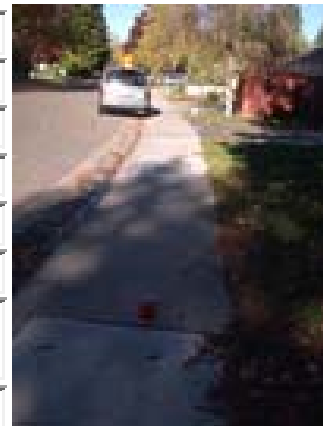
Barrier Type: Cross Slope - Existing (5.0% or more)

Code Ref: CBC 1133B.7.1.3 and ADA/ABA 403.3

As Built Meas: 655 Quantity: LF

Description: Cross slope exceeds 2.0% (5.0% or more)

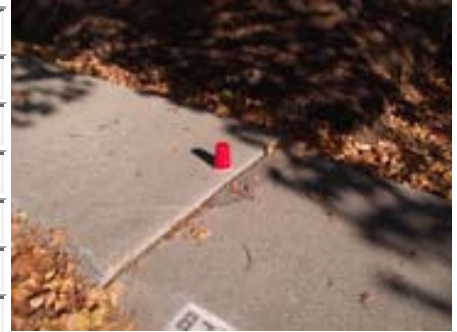
Barrier Type: Abrupt Change in Level - > 1/2"

Code Ref: CBC 1133B.7.1 and ADA/ABA 303.3

As Built Meas: 4 Quantity: LF

Description: Change in level greater than 1/2"

Solution: Grind or repair sidewalk to remove trip hazard

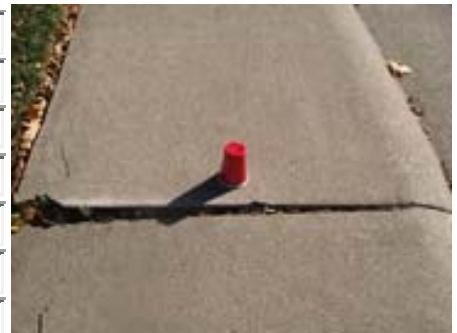
Barrier Type: Abrupt Change in Level - > 1/2"

Code Ref: CBC 1127B.5.3 and ADA/ABA 303.3

As Built Meas: 4 Quantity: SF

Description: Change in level greater than 1/2" in curb ramp

Solution: Grind or repair to remove trip hazard

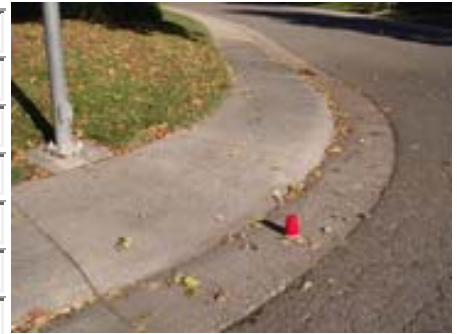
Barrier Type: No Curb Ramp - Depressed Existing Curb

Code Ref: CBC 1127B.5.1 and ADA/ABA 402.2

As Built Meas: 1 Quantity: EACH

Description: No compliant curb cut at corner (intersection)

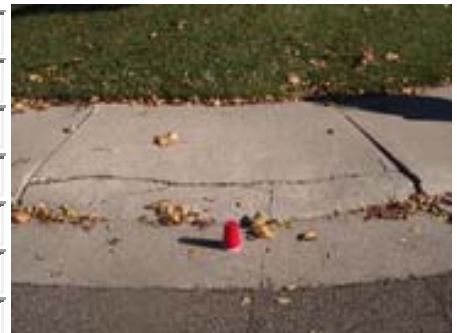
Barrier Type: No Curb Ramp - Depressed Existing Curb

Code Ref: CBC 1127B.5.1 and ADA/ABA 402.2

As Built Meas: 1 Quantity: EACH

Description: No compliant curb cut at corner (intersection)

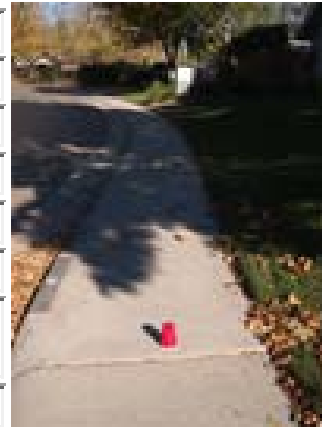
Barrier Type: Cross Slope - Existing (4.1% to 4.9%)

Code Ref: CBC 1133B.7.1.3 and ADA/ABA 403.3

As Built Meas: 201 Quantity: LF

Description: Cross slope exceeds 2.0% (4.1% to 4.9%)

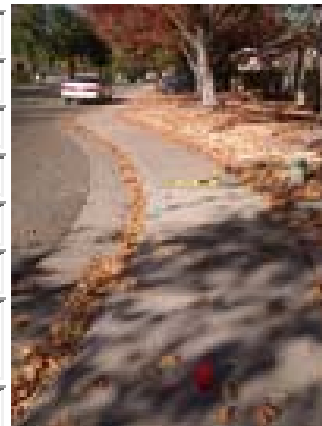
Barrier Type: Cross Slope - Existing (5.0% or more)

Code Ref: CBC 1133B.7.1.3 and ADA/ABA 403.3

As Built Meas: 247 Quantity: LF

Description: Cross slope exceeds 2.0% (5.0% or more)

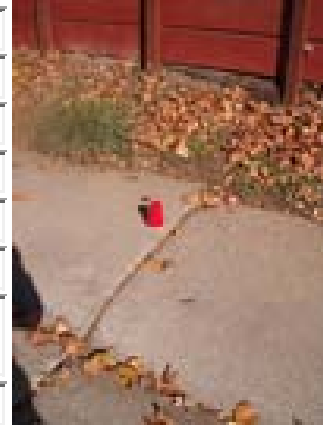
Barrier Type: Abrupt Change in Level - > 1/2"

Code Ref: CBC 1133B.7.1 and ADA/ABA 303.3

As Built Meas: 4 Quantity: LF

Description: Change in level greater than 1/2"

Solution: Grind or repair sidewalk to remove trip hazard

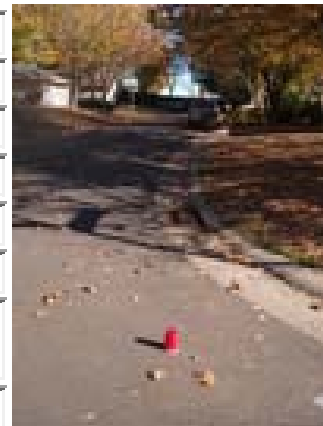
Location: Brokenfeather Wy - South

Barrier Type: Shoulder Cross Slope - Existing (4.1% to 4.9%)

Code Ref: CBC 1133B.7.1.3 and ADA/ABA 403.3

As Built Meas: 219 Quantity: LF

Description: Cross slope exceeds 2.0% (4.1% to 4.9%)

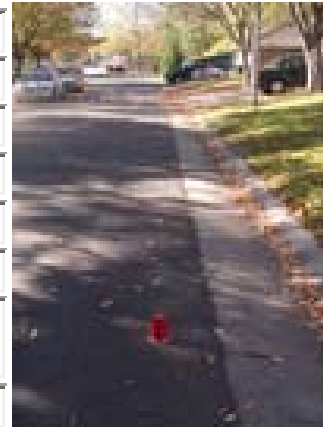
Location: Brokenfeather Wy - North

Barrier Type: Shoulder Cross Slope - Existing (3.1% to 4.0%)

Code Ref: CBC 1133B.7.1.3 and ADA/ABA 403.3

As Built Meas: 221 Quantity: LF

Description: Cross slope exceeds 2.0% (3.1% to 4.0%)
