SZS CONSULTING GROUP

DRAFT ADA TRANSITION PLAN UPDATE
NEIGHBORHOOD AREA 3 CHANT
SEPTEMBER 20, 2011

CITY OF CITRUS HEIGHTS

Citrus Heights Area Three (CHANT)

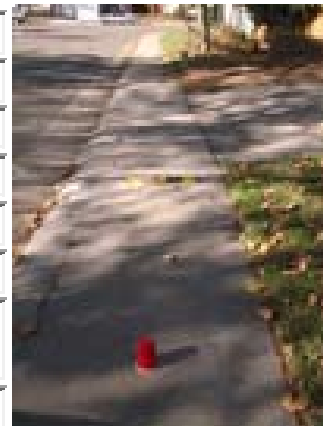
Barrier Type: Cross Slope - Existing (4.1% to 4.9%)

Description: Cross slope exceeds 2.0% (4.1% to 4.9%)

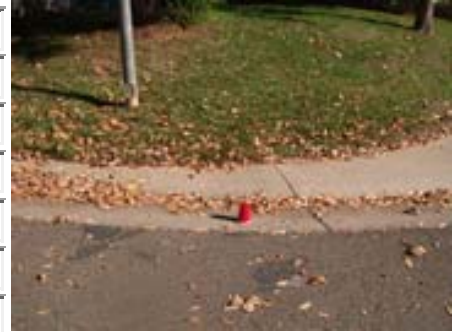
Barrier Type: No Curb Ramp - Depressed Existing Curb

Description: No compliant curb cut at corner (intersection)

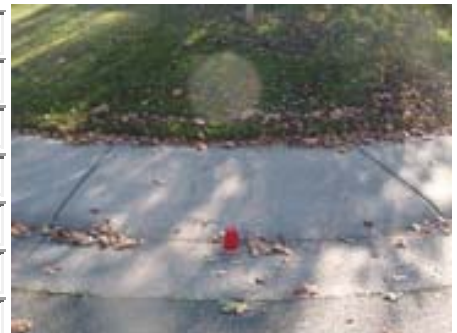
Barrier Type: No Curb Ramp - Depressed Existing Curb

Description: No compliant curb cut at corner (intersection)

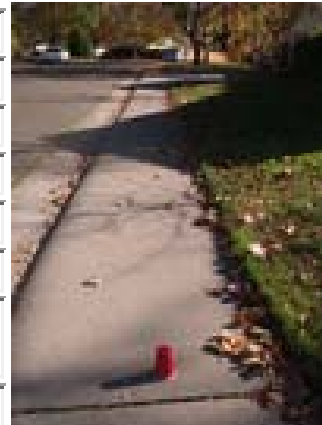
Barrier Type: Cross Slope - Existing (5.0% or more)

Description: Cross slope exceeds 2.0% (5.0% or more)

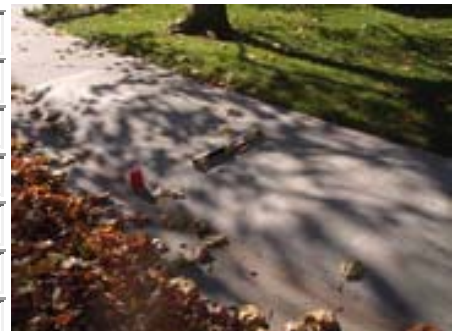
Barrier Type: Elbow in Sidewalk - Cross Slope (5.0% or more)

Description: Cross slope at elbow exceeds 2.0% (5.0% or more)

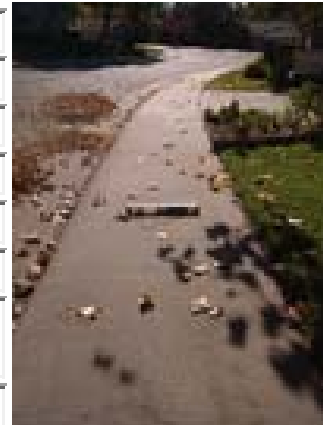
Barrier Type: Cross Slope - Existing (5.0% or more)

Description: Cross slope exceeds 2.0% (5.0% or more)

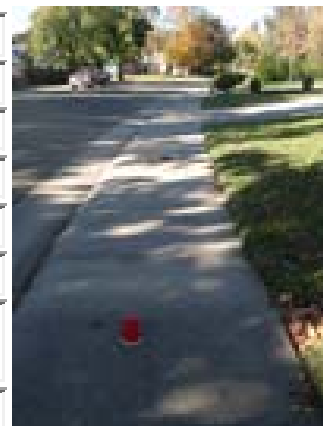
Barrier Type: Cross Slope - Existing (4.1% to 4.9%)

Description: Cross slope exceeds 2.0% (4.1% to 4.9%)

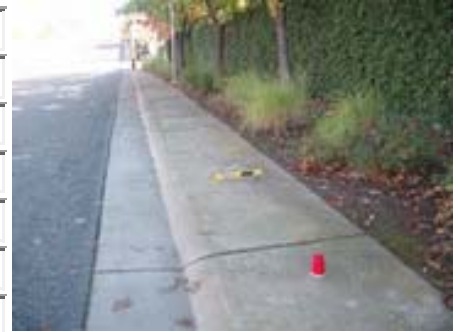
Barrier Type: Cross Slope - Existing (3.1% to 4.0%)

Description: Cross slope exceeds 2.0% (3.1% to 4.0%)

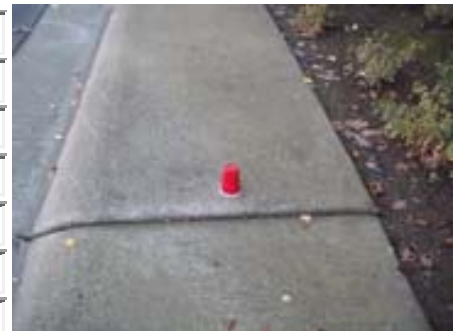
Barrier Type: Abrupt Change in Level - > 1/2"

Description: Change in level greater than 1/2"

Solution: Grind or repair sidewalk to remove trip hazard

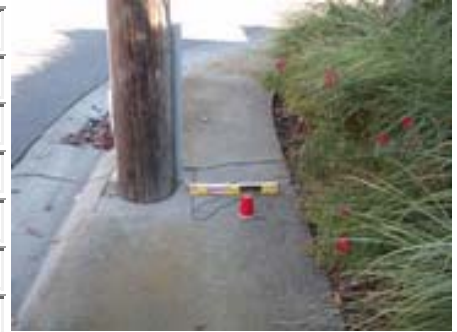
Barrier Type: Clear Width - Existing ($\leq 31"$ or less)

Description: Pedestrian route is not min. 48" wide ($\leq 31"$ or less)

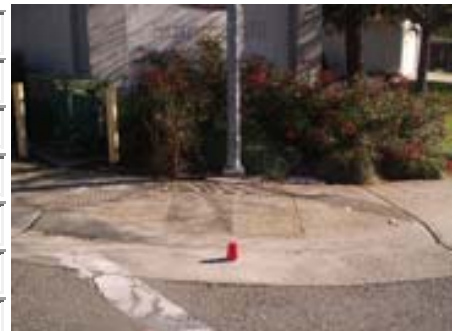
Barrier Type: 12" Grooves - Existing (4.1% to 4.9%)

Description: 12" grooves at top of curb ramp are not level (4.1% to 4.9%)

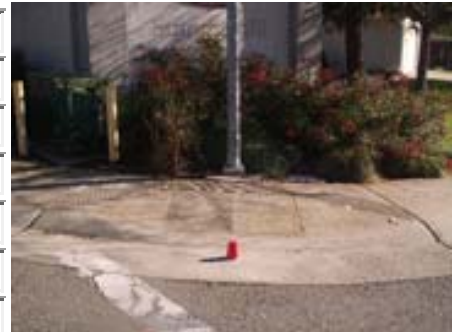
Barrier Type: Perpendicular Ramp Landing - New Construction

Description: Curb ramp top landing not min. 48" deep

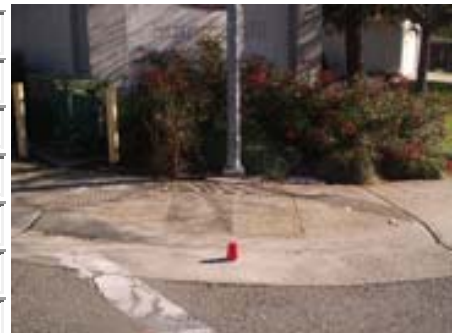
Barrier Type: Detectable Warnings - Truncated Domes

Description: No truncated domes provided at curb ramp

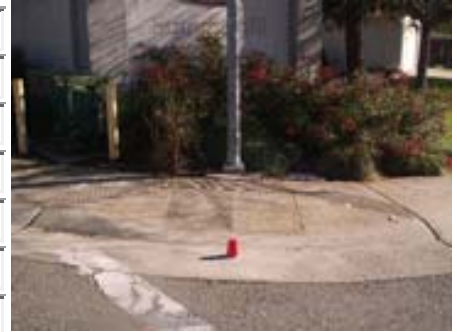
Barrier Type: Gutter Slope - Existing (6.6% to 8.2%)

Description: Gutter slope exceeds 5.0% (6.6% to 8.2%)

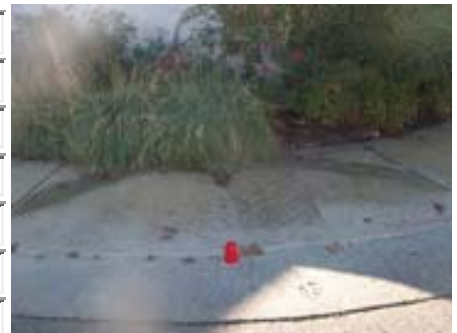
Barrier Type: 12" Grooves - Existing (3.1% to 4.0%)

Description: 12" grooves at top of curb ramp are not level (3.1% to 4.0%)

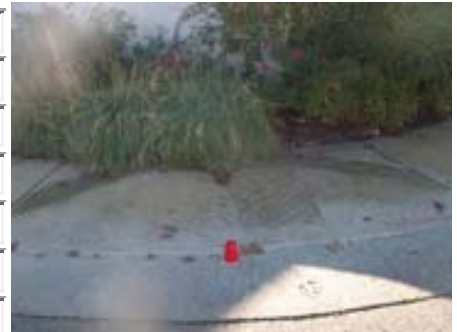
Barrier Type: Perpendicular Ramp Landing - New Construction

Description: Curb ramp top landing not min. 48" deep

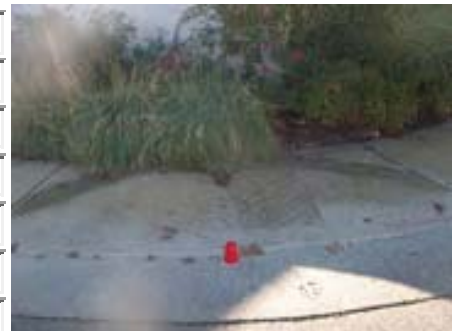
Barrier Type: Detectable Warnings - Truncated Domes

Description: No truncated domes provided at curb ramp

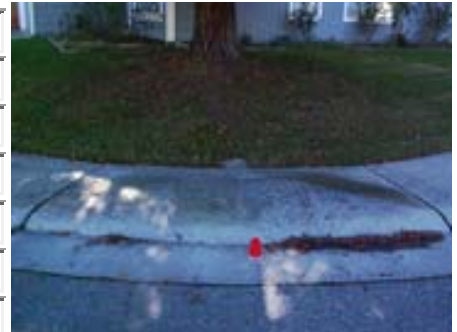
Barrier Type: Detectable Warnings - Truncated Domes

Description: No truncated domes provided at curb ramp

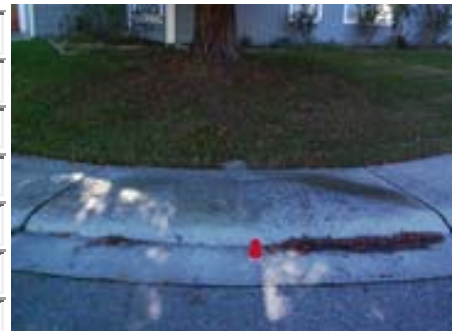
Barrier Type: Perpendicular Ramp Landing - New Construction

Description: Curb ramp top landing not min. 48" deep

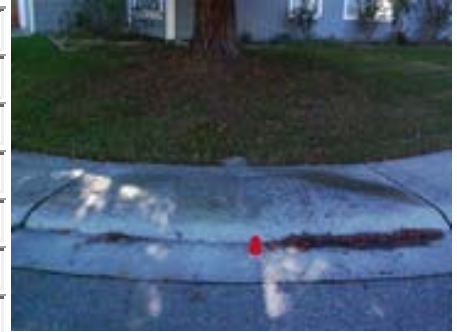
Barrier Type: Gutter Slope - Existing (6.6% to 8.2%)

Description: Gutter slope exceeds 5.0% (6.6% to 8.2%)

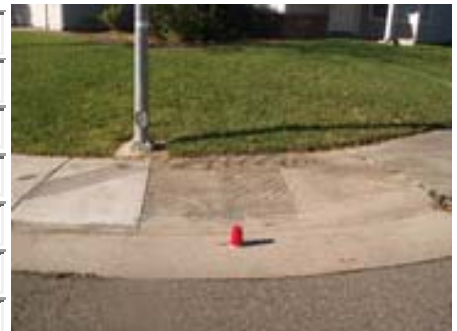
Barrier Type: 12" Grooves - Existing (3.1% to 4.0%)

Description: 12" grooves at top of curb ramp are not level (3.1% to 4.0%)

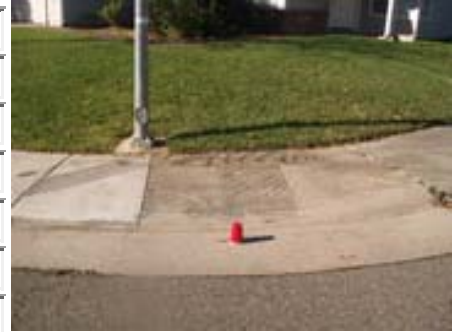
Barrier Type: Perpendicular Ramp Landing - New Construction

Description: Curb ramp top landing not min. 48" deep

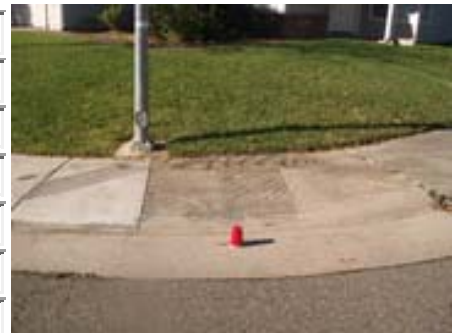
Barrier Type: Detectable Warnings - Truncated Domes

Description: No truncated domes provided at curb ramp

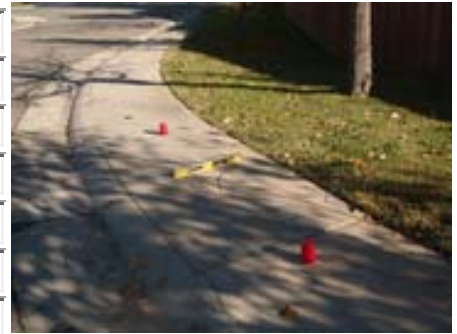
Barrier Type: Cross Slope - Existing (4.1% to 4.9%)

Description: Cross slope exceeds 2.0% (4.1% to 4.9%)

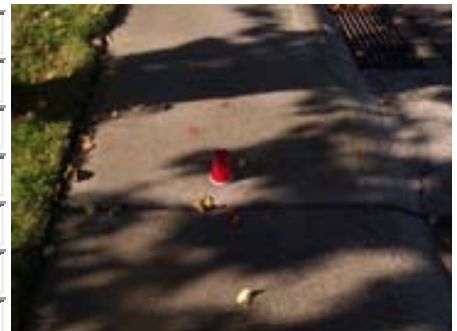
Barrier Type: Abrupt Change in Level - > 1/2"

Description: Change in level greater than 1/2"

Solution: Grind or repair sidewalk to remove trip hazard

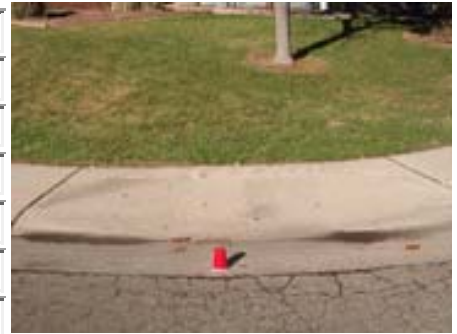
Barrier Type: 12" Grooves - Existing (>5.0%)

Description: 12" grooves at top of curb ramp are not level (>5.0%)

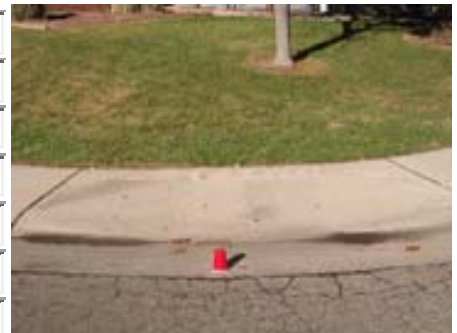
Barrier Type: Perpendicular Ramp Landing - New Construction

Description: Curb ramp top landing not min. 48" deep

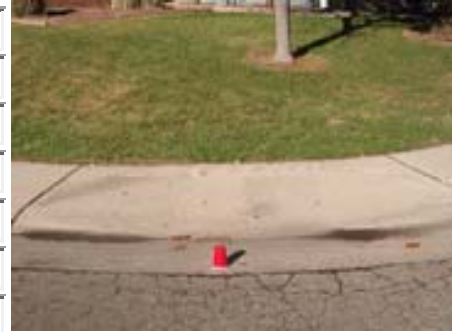
Barrier Type: Detectable Warnings - Truncated Domes

Description: No truncated domes provided at curb ramp

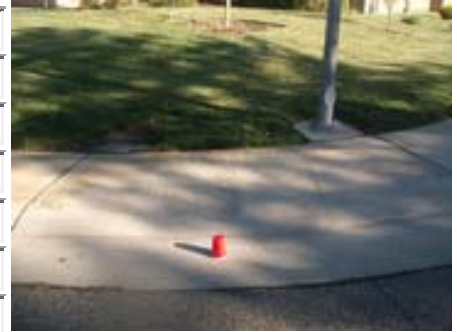
Barrier Type: 12" Grooves - Existing (4.1% to 4.9%)

Description: 12" grooves at top of curb ramp are not level (4.1% to 4.9%)

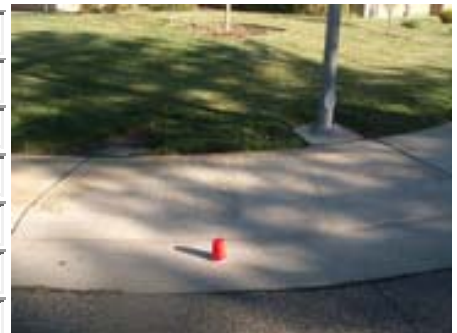
Barrier Type: Perpendicular Ramp Landing - New Construction

Description: Curb ramp top landing not min. 48" deep

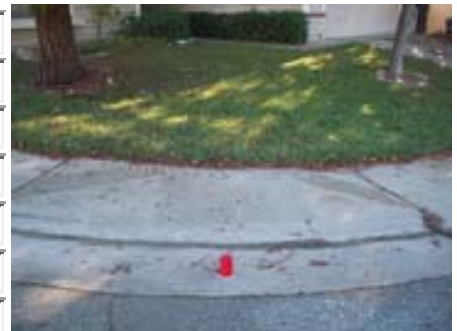
Barrier Type: 12" Grooves - Existing (4.1% to 4.9%)

Description: 12" grooves at top of curb ramp are not level (4.1% to 4.9%)

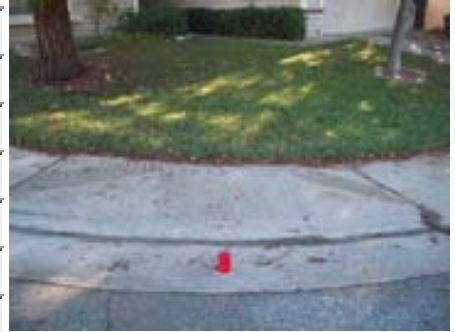
Barrier Type: Perpendicular Ramp Landing - New Construction

Description: Curb ramp top landing not min. 48" deep

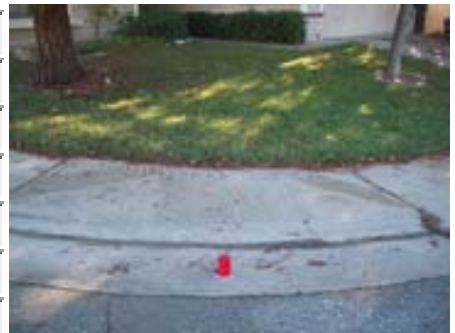
Barrier Type: Detectable Warnings - Truncated Domes

Description: No truncated domes provided at curb ramp

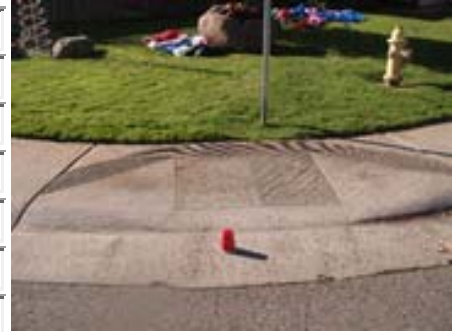
Field Date:	11/29/2010	Report Date:	11/29/2010	Barrier #:	2814A
Location:	Goldenwood Cir and Woodenfield Ct - Corner D				
X Coordinate:	-121.32881				
Y Coordinate:	38.6871				
Barrier Area:	Curb Ramps				
Barrier Type:	Perpendicular Ramp Landing - New Construction				
Code Ref:	CBC 1127B.5.4 and ADA/ABA 406.4

As Built Meas:	1	Quantity:	EACH
Description:	Curb ramp top landing not min. 48" deep		
As Built Desc:	No top landing provided		
Solution:	Demolish existing and construct new transition		
Bar. Severity:	1 Necessary	Cost Estimate:	\$250.00
Implementation Priority:	4	Facility Function:	
Implementation Phase:		Implementation Date:	
Official Responsible:			
Notes:	Two - way intersection. Corners C,D

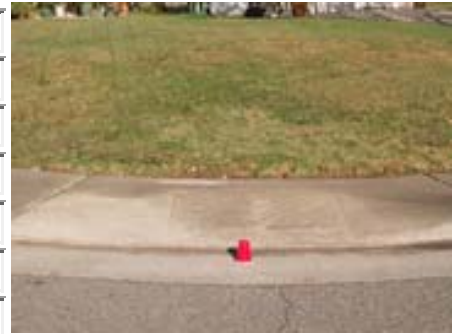
Barrier Type: 12" Grooves - Existing (3.1% to 4.0%)

Description: 12" grooves at top of curb ramp are not level (3.1% to 4.0%)

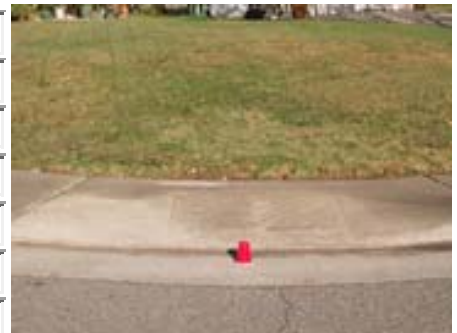
Barrier Type: Perpendicular Ramp Landing - New Construction

Description: Curb ramp top landing not min. 48" deep

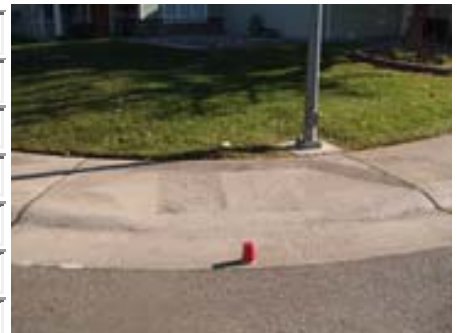
Barrier Type: 12" Grooves - Existing (3.1% to 4.0%)

Description: 12" grooves at top of curb ramp are not level (3.1% to 4.0%)

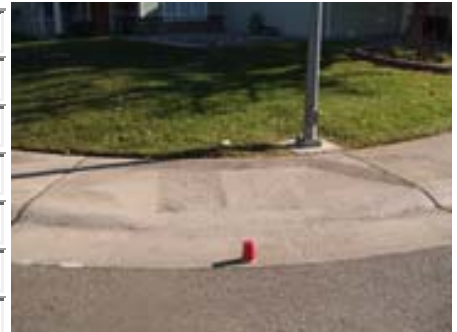
Barrier Type: Perpendicular Ramp Landing - New Construction

Description: Curb ramp top landing not min. 48" deep

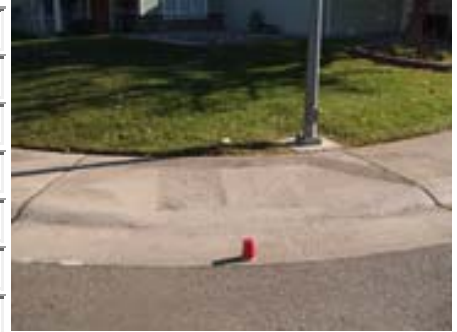
Barrier Type: Gutter Slope - Existing (5.9% - 6.5%)

Description: Gutter slope exceeds 5.0% (5.9% - 6.5%)

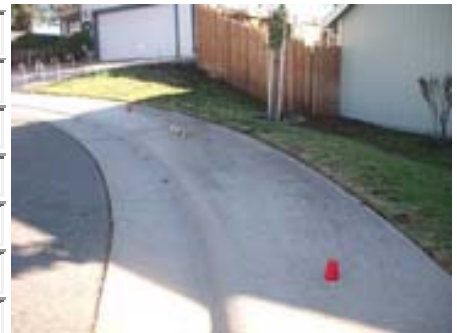
Barrier Type: Running Slope (Existing)

Description: Running slope exceeds 5.0%

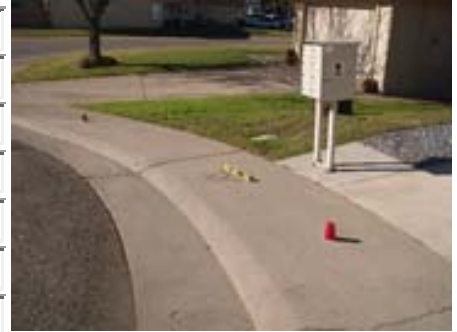
Barrier Type: Running Slope (Existing)

Code Ref: CBC 1133B.7.3 and ADA/ABA 403.3

As Built Meas: 16 Quantity: LF

Description: Running slope exceeds 5.0%

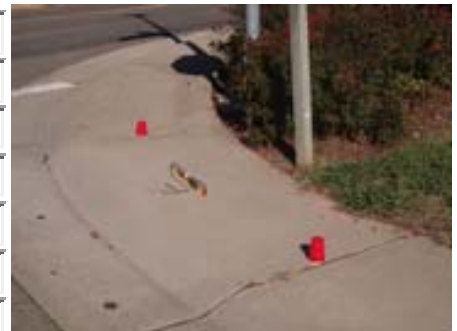
Barrier Type: Running Slope (Existing)

Code Ref: CBC 1133B.7.3 and ADA/ABA 403.3

As Built Meas: 8 Quantity: LF

Description: Running slope exceeds 5.0%

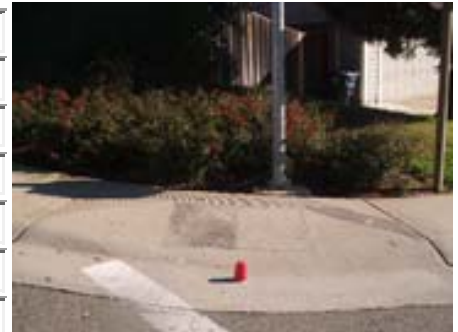
Barrier Type: 12" Grooves - Existing (>5.0%)

Code Ref: CBC 1127B.5.6

As Built Meas: 1 Quantity: EACH

Description: 12" grooves at top of curb ramp are not level (>5.0%)

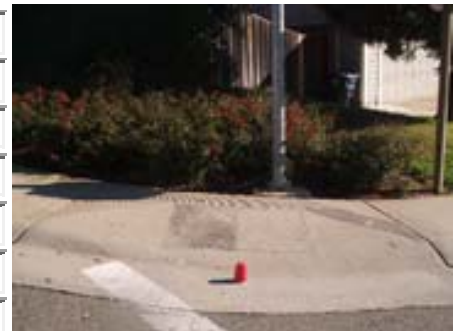
Barrier Type: Flares - Existing (11.1% or more)

Code Ref: CBC 1127B.5.3 and ADA/ABA 406.3

As Built Meas: 1 Quantity: EACH

Description: Ramp flare slope exceeds 10.0% (11.1% or more)

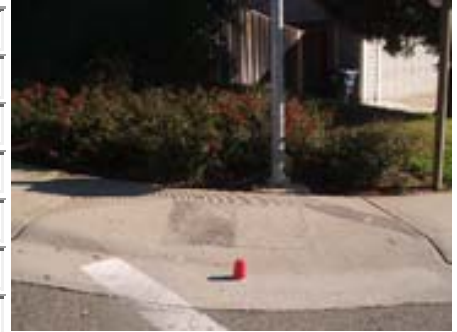
Barrier Type: Perpendicular Ramp Landing - New Construction

Code Ref: CBC 1127B.5.4 and ADA/ABA 406.4

As Built Meas: 1 Quantity: EACH

Description: Curb ramp top landing not min. 48" deep

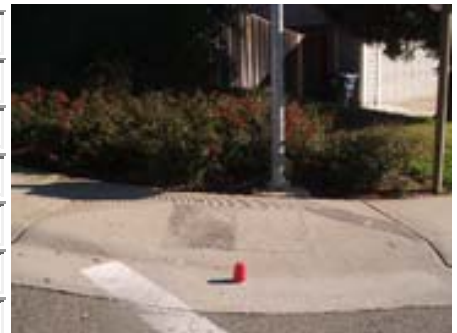
Barrier Type: Detectable Warnings - Truncated Domes

Code Ref: CBC 1127B.5.7 and ADA/ABA 705.1.3

As Built Meas: 1 Quantity: EACH

Description: No truncated domes provided at curb ramp

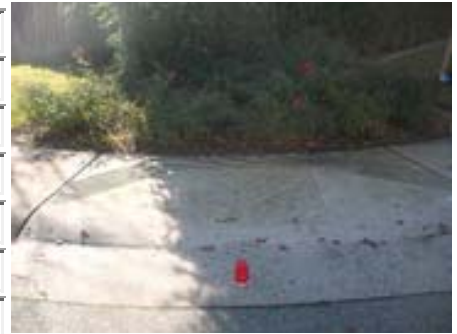
Barrier Type: 12" Grooves - Existing (2.1% to 3.0%)

Code Ref: CBC 1127B.5.6

As Built Meas: 1 Quantity: EACH

Description: 12" grooves at top of curb ramp are not level (2.1% to 3.0%)

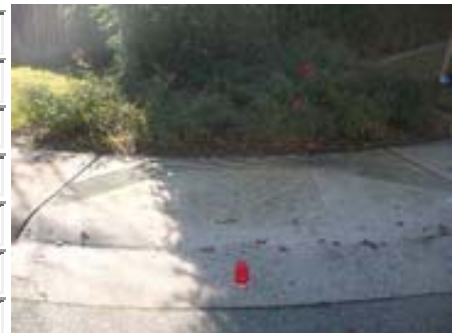
Barrier Type: Perpendicular Ramp Landing - New Construction

Code Ref: CBC 1127B.5.4 and ADA/ABA 406.4

As Built Meas: 1 Quantity: EACH

Description: Curb ramp top landing not min. 48" deep

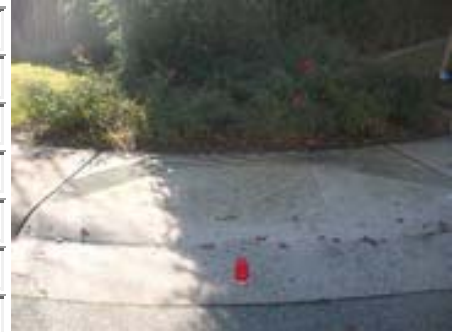
Barrier Type: Detectable Warnings - Truncated Domes

Code Ref: CBC 1127B.5.7 and ADA/ABA 705.1.3

As Built Meas: 1 Quantity: EACH

Description: No truncated domes provided at curb ramp

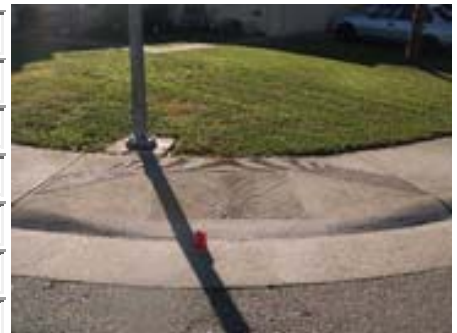
Barrier Type: Perpendicular Ramp Landing - New Construction

Code Ref: CBC 1127B.5.4 and ADA/ABA 406.4

As Built Meas: 1 Quantity: EACH

Description: Curb ramp top landing not min. 48" deep

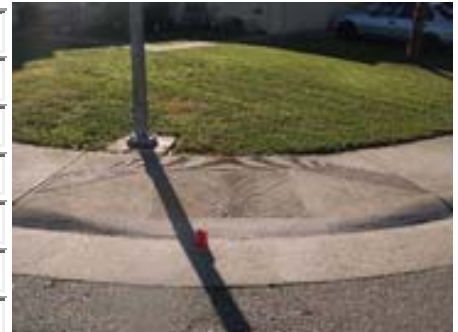
Barrier Type: Detectable Warnings - Truncated Domes

Code Ref: CBC 1127B.5.7 and ADA/ABA 705.1.3

As Built Meas: 1 Quantity: EACH

Description: No truncated domes provided at curb ramp

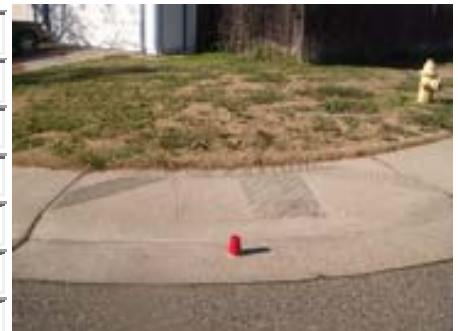
Barrier Type: 12" Grooves - Existing (3.1% to 4.0%)

Code Ref: CBC 1127B.5.6

As Built Meas: 1 Quantity: EACH

Description: 12" grooves at top of curb ramp are not level (3.1% to 4.0%)

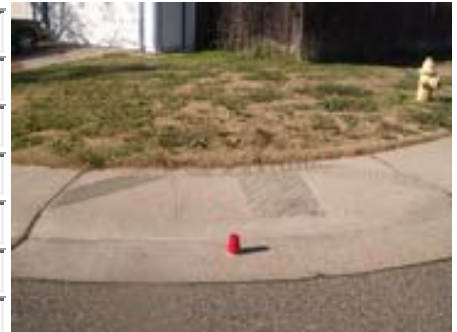
Barrier Type: Perpendicular Ramp Landing - New Construction

Code Ref: CBC 1127B.5.4 and ADA/ABA 406.4

As Built Meas: 1 Quantity: EACH

Description: Curb ramp top landing not min. 48" deep

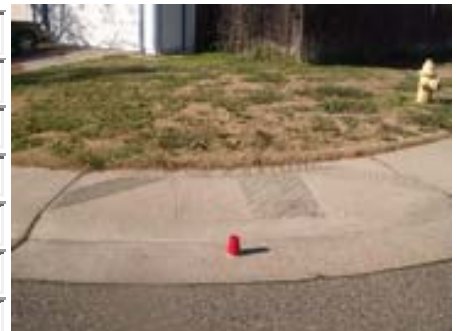
Barrier Type: Detectable Warnings - Truncated Domes

Code Ref: CBC 1127B.5.7 and ADA/ABA 705.1.3

As Built Meas: 1 Quantity: EACH

Description: No truncated domes provided at curb ramp

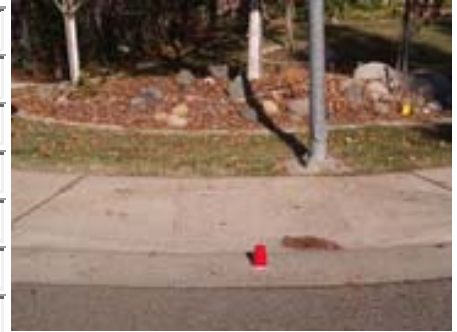
Barrier Type: 12" Grooves - Existing (3.1% to 4.0%)

Code Ref: CBC 1127B.5.6

As Built Meas: 1 Quantity: EACH

Description: 12" grooves at top of curb ramp are not level (3.1% to 4.0%)

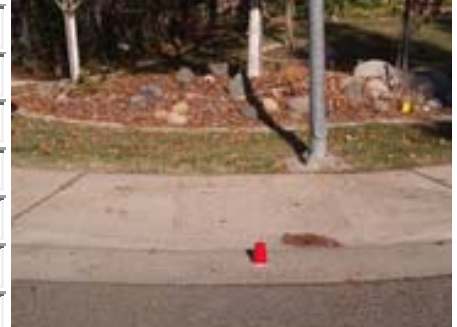
Barrier Type: Perpendicular Ramp Landing - New Construction

Code Ref: CBC 1127B.5.4 and ADA/ABA 406.4

As Built Meas: 1 Quantity: EACH

Description: Curb ramp top landing not min. 48" deep

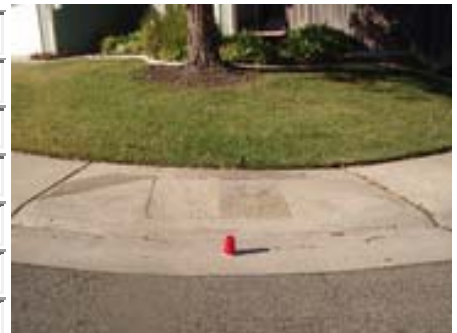
Barrier Type: 12" Grooves - Existing (3.1% to 4.0%)

Code Ref: CBC 1127B.5.6

As Built Meas: 1 Quantity: EACH

Description: 12" grooves at top of curb ramp are not level (3.1% to 4.0%)

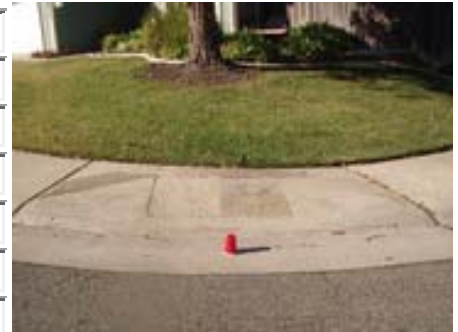
Field Date:	11/29/2010	Report Date:	11/29/2010	Barrier #:	2825B
Location:	Goldenwood Cir and Hill Shade Ct - Corner B				
X Coordinate:	-121.32758				
Y Coordinate:	38.68788				
Barrier Area:	Curb Ramps				
Barrier Type:	Perpendicular Ramp Landing - New Construction				
Code Ref:	CBC 1127B.5.4 and ADA/ABA 406.4

As Built Meas:	1	Quantity:	EACH	
Description:	Curb ramp top landing not min. 48" deep			
As Built Desc:	No top landing provided			
Solution:	Demolish existing and construct new transition			
Bar. Severity:	1 Necessary	Cost Estimate:	\$0.00	Status:
Implementation Priority:	4	Facility Function:		
Implementation Phase:		Implementation Date:		
Official Responsible:				
Notes:	Two - way intersection. Corners A,B

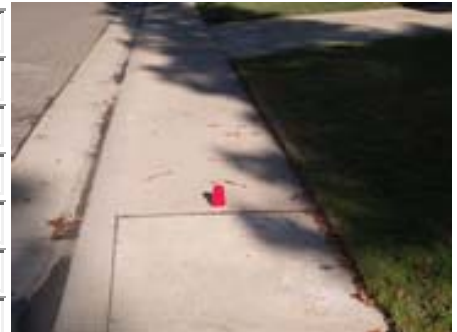
Barrier Type: Abrupt Change in Level - > 1/2"

Code Ref: CBC 1133B.7.1 and ADA/ABA 303.3

As Built Meas: 4 Quantity: LF

Description: Change in level greater than 1/2"

Solution: Grind or repair sidewalk to remove trip hazard

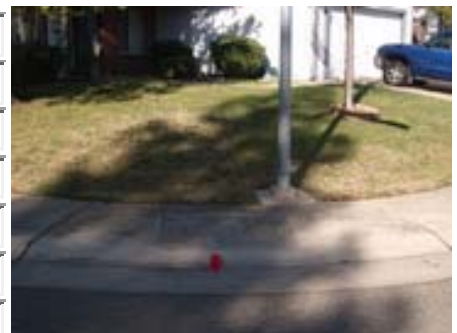
Barrier Type: 12" Grooves - Existing (3.1% to 4.0%)

Code Ref: CBC 1127B.5.6

As Built Meas: 1 Quantity: EACH

Description: 12" grooves at top of curb ramp are not level (3.1% to 4.0%)

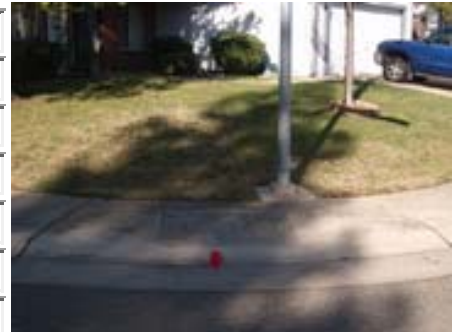
Barrier Type: Perpendicular Ramp Landing - New Construction

Code Ref: CBC 1127B.5.4 and ADA/ABA 406.4

As Built Meas: 1 Quantity: EACH

Description: Curb ramp top landing not min. 48" deep

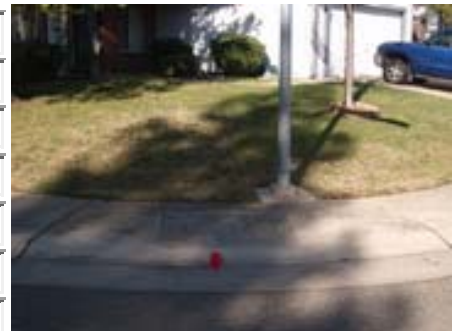
Barrier Type: Detectable Warnings - Truncated Domes

Code Ref: CBC 1127B.5.7 and ADA/ABA 705.1.3

As Built Meas: 1 Quantity: EACH

Description: No truncated domes provided at curb ramp

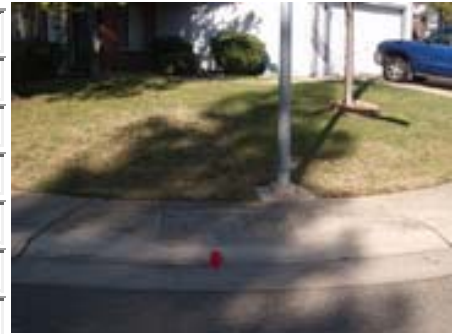
Barrier Type: Gutter Slope - Existing (5.9% - 6.5%)

Code Ref: CBC 1127B.5.3 and ADA/ABA 406.2

As Built Meas: 6 Quantity: SF

Description: Gutter slope exceeds 5.0% (5.9% - 6.5%)

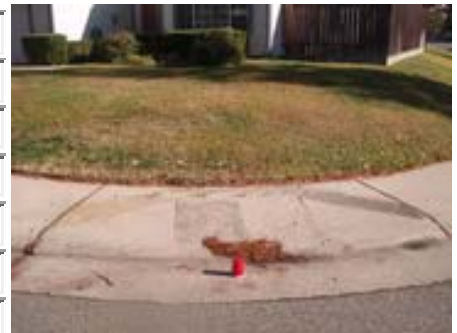
Barrier Type: 12" Grooves - Existing (3.1% to 4.0%)

Code Ref: CBC 1127B.5.6

As Built Meas: 1 Quantity: EACH

Description: 12" grooves at top of curb ramp are not level (3.1% to 4.0%)

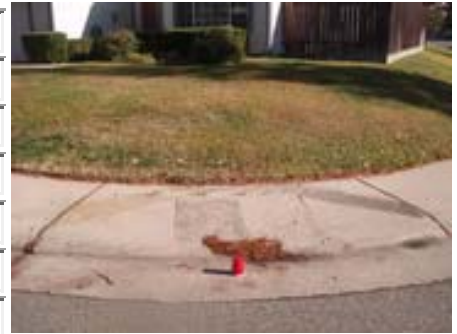
Barrier Type: Perpendicular Ramp Landing - New Construction

Code Ref: CBC 1127B.5.4 and ADA/ABA 406.4

As Built Meas: 1 Quantity: EACH

Description: Curb ramp top landing not min. 48" deep

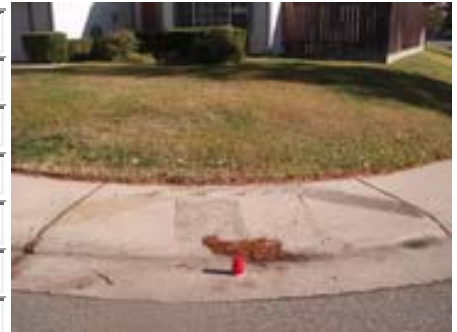
Barrier Type: Gutter Slope - Existing (6.6% to 8.2%)

Code Ref: CBC 1127B.5.3 and ADA/ABA 406.2

As Built Meas: 6 Quantity: SF

Description: Gutter slope exceeds 5.0% (6.6% to 8.2%)

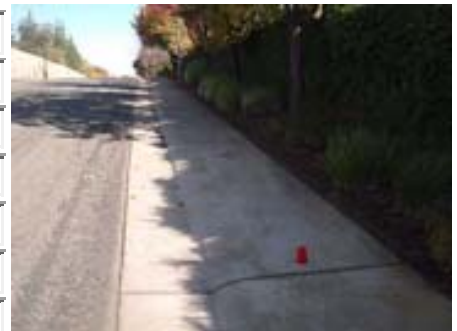
Barrier Type: Running Slope (Existing)

Code Ref: CBC 1133B.7.3 and ADA/ABA 403.3

As Built Meas: 80 Quantity: LF

Description: Running slope exceeds 5.0%

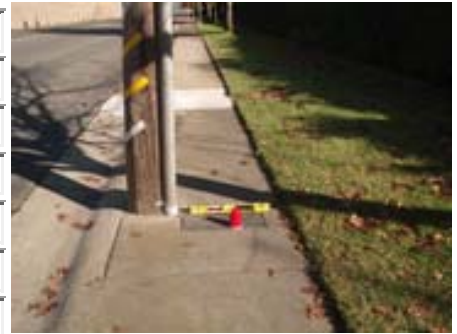
Field Date:	11/29/2010	Report Date:	11/29/2010	Barrier #:	2830
Location:	Verner Ave - East				
X Coordinate:	-121.32974				
Y Coordinate:	38.68812				
Barrier Area:	Sidewalks				
Barrier Type:	Clear Width - Existing ($\leq 31"$ or less)				
Code Ref:	CBC 1133B.7.1

As Built Meas:	4	Quantity:	LF	
Description:	Pedestrian route is not min. 48" wide ($\leq 31"$ or less)			
As Built Desc:	26" clear width due to pole			
Solution:	Demolish existing and construct new route			
Bar. Severity:	1 Necessary	Cost Estimate:	\$500.00	Status:
Implementation Priority:	4	Facility Function:		
Implementation Phase:		Implementation Date:		
Official Responsible:				
Notes:

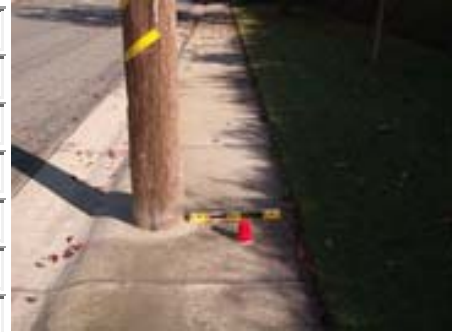
Barrier Type: Clear Width - Existing ($\leq 31"$ or less)

Code Ref: CBC 1133B.7.1

As Built Meas: 4 Quantity: LF

Description: Pedestrian route is not min. 48" wide ($\leq 31"$ or less)

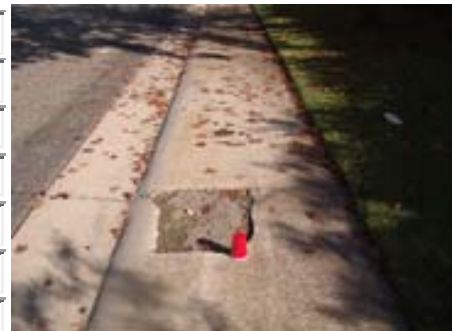
Barrier Type: Surface Condition - Damaged

Code Ref: CBC 1133B.7.1 and ADA/ABA 302.1

As Built Meas: 4 Quantity: LF

Description: Surface is not firm and stable (cracked, broken or loose soil, etc.)

As Built Desc: Broken concrete

Solution: Repair surface to make firm and stable

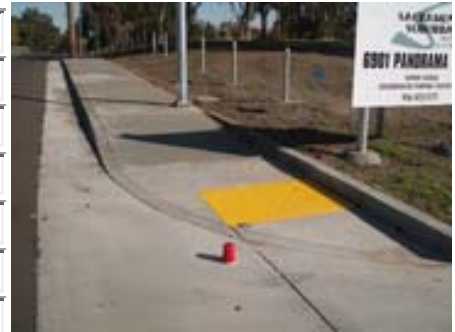
Field Date:	11/29/2010	Report Date:	11/29/2010	Barrier #:	2834
Location:	Verner Ave - East - Corner B				
X Coordinate:	-121.32796				
Y Coordinate:	38.68974				
Barrier Area:	Curb Ramps				
Barrier Type:	12" Grooves - New Construction				
Code Ref:	CBC 1127B.5.6

As Built Meas:	1	Quantity:	EACH
Description:	12" grooves at top of curb ramp are not level (3.1% to 4.0%)		
As Built Desc:	3.8% at 12" grooves - New Construction		
Solution:	Demolish existing and construct new curb ramp		
Bar. Severity:	1 Necessary	Cost Estimate:	\$2,500.00
Implementation Priority:	4	Facility Function:	
Implementation Phase:		Implementation Date:	
Official Responsible:

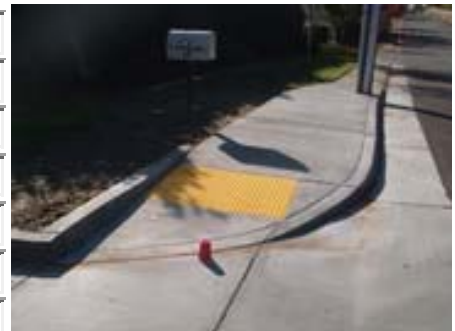
Field Date:	11/29/2010	Report Date:	11/29/2010	Barrier #:	2835
Location:	Verner Ave - East - Corner C				
X Coordinate:	-121.32806				
Y Coordinate:	38.68969				
Barrier Area:	Curb Ramps				
Barrier Type:	12" Grooves - New Construction				
Code Ref:	CBC 1127B.5.6

As Built Meas:	1	Quantity:	EACH
Description:	12" grooves at top of curb ramp are not level (3.1% to 4.0%)		
As Built Desc:	3.5% at 12" grooves - New Construction		
Solution:	Demolish existing and construct new curb ramp		
Bar. Severity:	1 Necessary	Cost Estimate:	\$2,500.00
Implementation Priority:	4	Facility Function:	
Implementation Phase:		Implementation Date:	
Official Responsible:

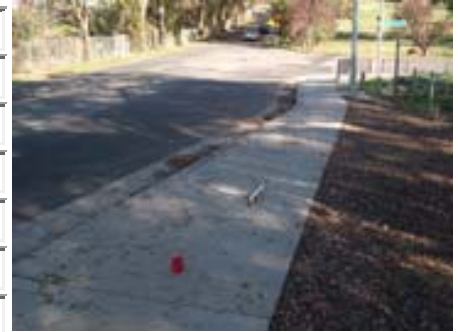
Field Date:	11/29/2010	Report Date:	11/29/2010	Barrier #:	2836
Location:	Verner Ave - East				
X Coordinate:	-121.32676				
Y Coordinate:	38.69089				
Barrier Area:	Sidewalks				
Barrier Type:	Running Slope (Existing)				
Code Ref:	CBC 1133B.7.3 and ADA/ABA 403.3

As Built Meas:	80	Quantity:	LF
Description:	Running slope exceeds 5.0%		
As Built Desc:	8.8% running slope		
Solution:	No remediation where sidewalk sloped as roadway		
Bar. Severity:	5 Technically Infeasible	Cost Estimate:	\$0.00
Implementation Priority:	4	Facility Function:	
Implementation Phase:		Implementation Date:	
Official Responsible:			
Notes:

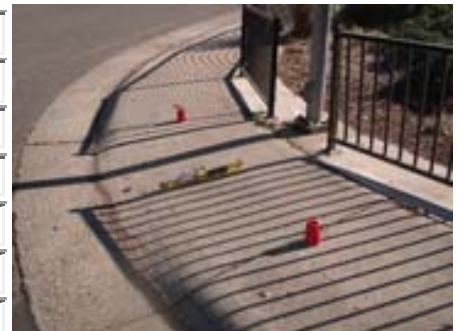
Field Date:	11/29/2010	Report Date:	11/29/2010	Barrier #:	2837
Location:	Verner Ave - East				
X Coordinate:	-121.32653				
Y Coordinate:	38.69103				
Barrier Area:	Sidewalks				
Barrier Type:	Elbow in Sidewalk - Cross Slope (5.0% or more)				
Code Ref:	CBC 1133B.7.1.3 and ADA/ABA 403.3

As Built Meas:	8	Quantity:	LF
Description:	Cross slope at elbow exceeds 2.0% (5.0% or more)		
As Built Desc:	10.0% cross slope		
Solution:	Demolish existing and construct new sidewalk without curb ramp		
Bar. Severity:	1 Necessary	Cost Estimate:	\$1,000.00
Implementation Priority:	4	Facility Function:	
Implementation Phase:		Implementation Date:	
Official Responsible:			
Notes:

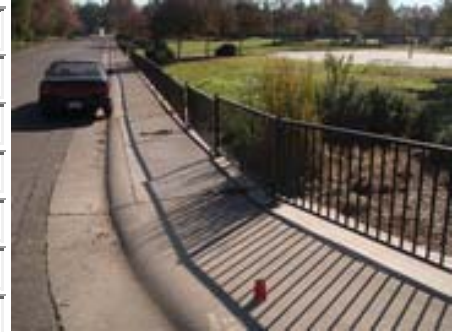
Barrier Type: Cross Slope - Existing (5.0% or more)

Code Ref: CBC 1133B.7.1.3 and ADA/ABA 403.3

As Built Meas: 593 Quantity: LF

Description: Cross slope exceeds 2.0% (5.0% or more)

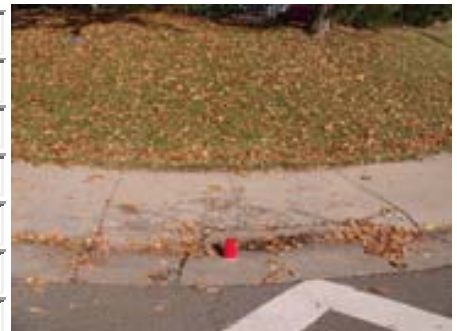
Barrier Type: No Curb Ramp - Depressed Existing Curb

Code Ref: CBC 1127B.5.1 and ADA/ABA 402.2

As Built Meas: 1 Quantity: EACH

Description: No compliant curb cut at corner (intersection)

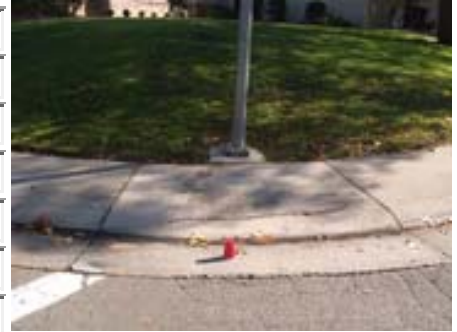
Barrier Type: No Curb Ramp - Depressed Existing Curb

Code Ref: CBC 1127B.5.1 and ADA/ABA 402.2

As Built Meas: 1 Quantity: EACH

Description: No compliant curb cut at corner (intersection)

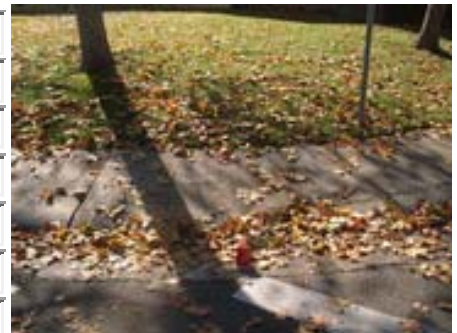
Barrier Type: No Curb Ramp - Depressed Existing Curb

Code Ref: CBC 1127B.5.1 and ADA/ABA 402.2

As Built Meas: 1 Quantity: EACH

Description: No compliant curb cut at corner (intersection)

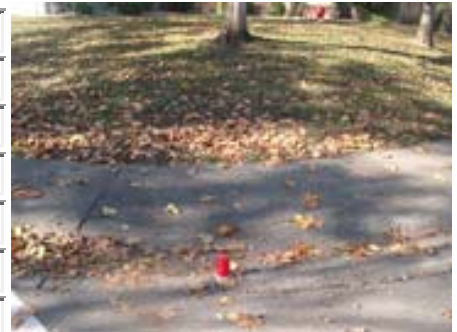
Barrier Type: No Curb Ramp - Depressed Existing Curb

Code Ref: CBC 1127B.5.1 and ADA/ABA 402.2

As Built Meas: 1 Quantity: EACH

Description: No compliant curb cut at corner (intersection)

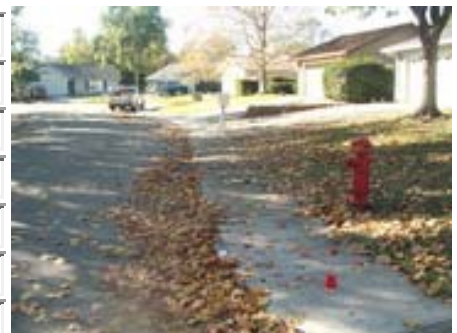
Barrier Type: Cross Slope - Existing (4.1% to 4.9%)

Code Ref: CBC 1133B.7.1.3 and ADA/ABA 403.3

As Built Meas: 181 Quantity: LF

Description: Cross slope exceeds 2.0% (4.1% to 4.9%)

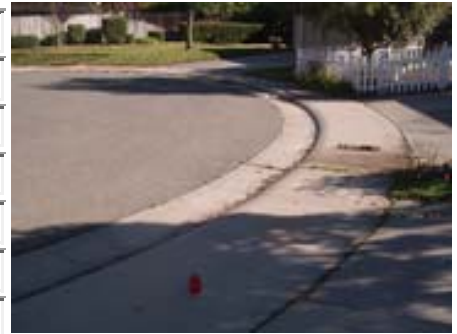
Field Date:	11/29/2010	Report Date:	11/29/2010	Barrier #:	2844A
Location:	High Sun Ct - East				
X Coordinate:	-121.32528				
Y Coordinate:	38.68943				
Barrier Area:	Sidewalks				
Barrier Type:	Cross Slope - Existing (5.0% or more)				
Code Ref:	CBC 1133B.7.1.3 and ADA/ABA 403.3

As Built Meas:	228	Quantity:	LF	
Description:	Cross slope exceeds 2.0% (5.0% or more)			
As Built Desc:	5.5% cross slope			
Solution:	Demolish existing and construct new route			
Bar. Severity:	1 Necessary	Cost Estimate:	\$28,500.00	Status:
Implementation Priority:	4	Facility Function:		
Implementation Phase:		Implementation Date:		
Official Responsible:				
Notes:

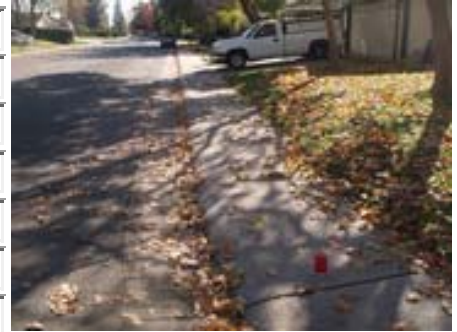
Barrier Type: Cross Slope - Existing (5.0% or more)

As Built Meas: 159 Quantity: LF

Description: Cross slope exceeds 2.0% (5.0% or more)

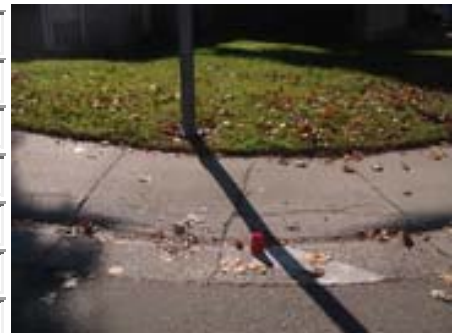
Barrier Type: No Curb Ramp - Depressed Existing Curb

As Built Meas: 1 Quantity: EACH

Description: No compliant curb cut at corner (intersection)

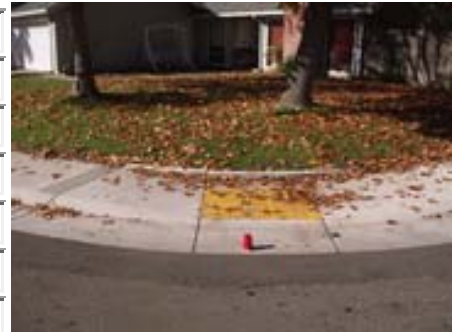
Barrier Type: 12" Grooves - New Construction

As Built Meas: 1 Quantity: EACH

Description: 12" grooves at top of curb ramp are not level (3.1% to 4.0%)

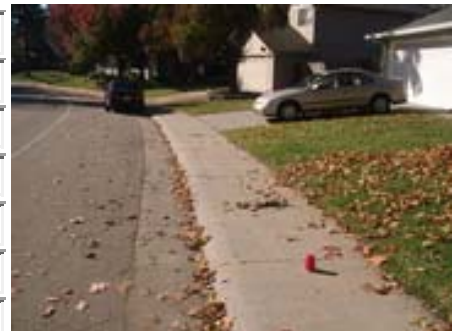
Barrier Type: Cross Slope - Existing (3.1% to 4.0%)

As Built Meas: 195 Quantity: LF

Description: Cross slope exceeds 2.0% (3.1% to 4.0%)

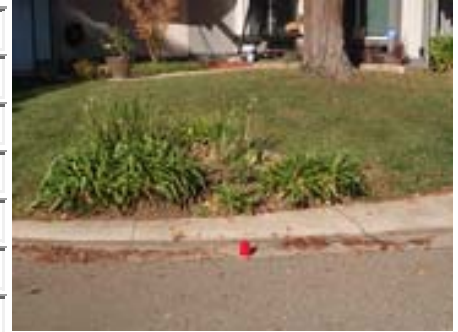
Barrier Type: No Curb Ramp

As Built Meas: 1 Quantity: EACH

Description: No curb cut at corner (intersection)

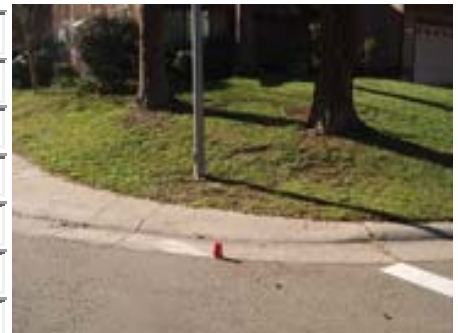
Barrier Type: No Curb Ramp

As Built Meas: 1 Quantity: EACH

Description: No curb cut at corner (intersection)

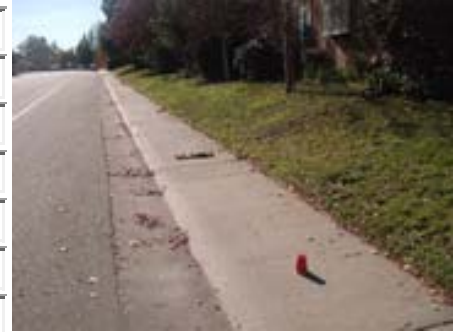
Barrier Type: Cross Slope - Existing (4.1% to 4.9%)

As Built Meas: 163 Quantity: LF

Description: Cross slope exceeds 2.0% (4.1% to 4.9%)

Bar. Severity: 2 Recommended Cost Estimate: \$20,375.00 Status:

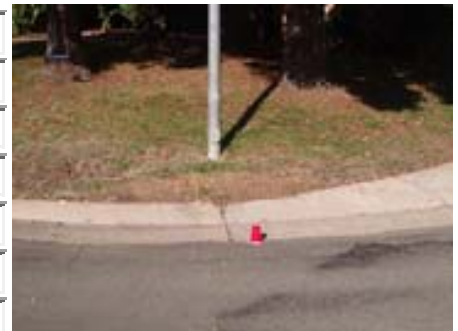
Barrier Type: No Curb Ramp

As Built Meas: 1 Quantity: EACH

Description: No curb cut at corner (intersection)

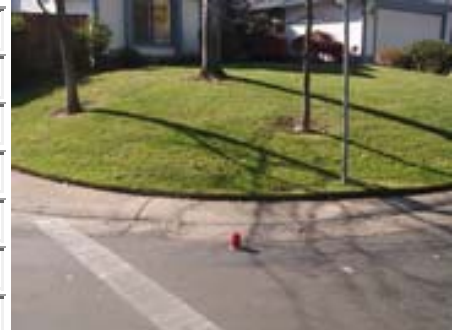
Barrier Type: No Curb Ramp

As Built Meas: 1 Quantity: EACH

Description: No curb cut at corner (intersection)

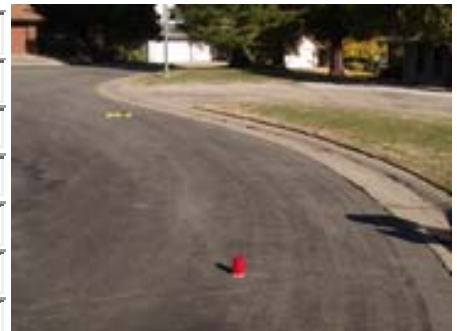
Barrier Type: Shoulder Cross Slope - Existing (5.0% or more)

As Built Meas: 80 Quantity: LF

Description: Cross slope exceeds 2.0% (5.0% or more)

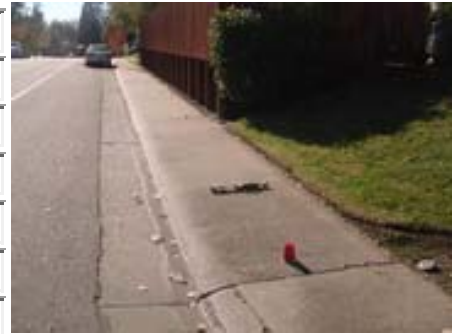
Field Date:	11/29/2010	Report Date:	11/29/2010	Barrier #:	2855
Location:	Indian River Dr - West				
X Coordinate:	-121.32524				
Y Coordinate:	38.68792				
Barrier Area:	Sidewalks				
Barrier Type:	Cross Slope - Existing (3.1% to 4.0%)				
Code Ref:	CBC 1133B.7.1.3 and ADA/ABA 403.3

As Built Meas:	343	Quantity:	LF
Description:	Cross slope exceeds 2.0% (3.1% to 4.0%)		
As Built Desc:	3.5% cross slope		
Solution:	Demolish existing and construct new route		
Bar. Severity:	3 Hindrance	Cost Estimate:	\$42,875.00
Implementation Priority:	2	Facility Function:	
Implementation Phase:		Implementation Date:	
Official Responsible:			
Notes:

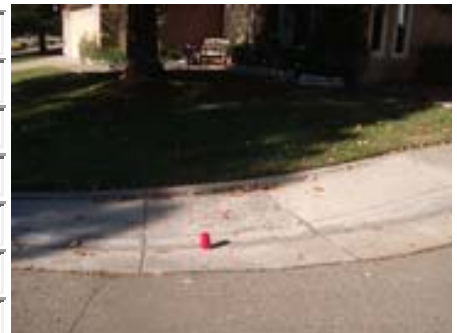
Field Date:	11/29/2010	Report Date:	11/29/2010	Barrier #:	2856A
Location:	Indian River Dr and Fire Water - Corner A				
X Coordinate:	-121.3257				
Y Coordinate:	38.68703				
Barrier Area:	Curb Ramps				
Barrier Type:	12" Grooves - Existing (3.1% to 4.0%)				
Code Ref:	CBC 1127B.5.6

As Built Meas:	1	Quantity:	EACH
Description:	12" grooves at top of curb ramp are not level (3.1% to 4.0%)		
As Built Desc:	3.6% at 12" grooves		
Solution:	Demolish existing and construct new curb ramp		
Bar. Severity:	3 Hindrance	Cost Estimate:	\$2,500.00
Implementation Priority:	2	Facility Function:	
Implementation Phase:		Implementation Date:	
Official Responsible:			
Notes:	Two - way intersection. Corners A,D

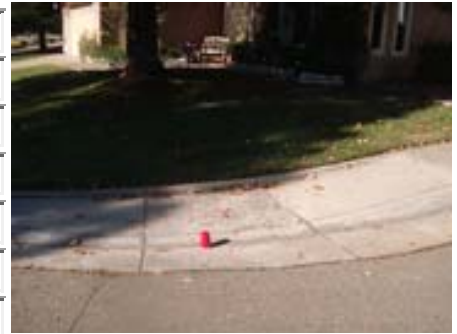
Barrier Type: Parallel Ramp Landing - Existing (3.1% to 4.0%)

As Built Meas: 1 Quantity: EACH

Description: Curb ramp landing or pan not level (3.1% to 4.0%)

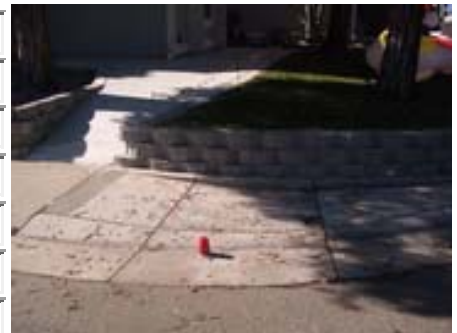
Barrier Type: Cross Slope - Existing (2.1% to 3.0%)

As Built Meas: 1 Quantity: EACH

Description: Ramp run cross slope exceeds 2.0% (2.1% to 3.0%)

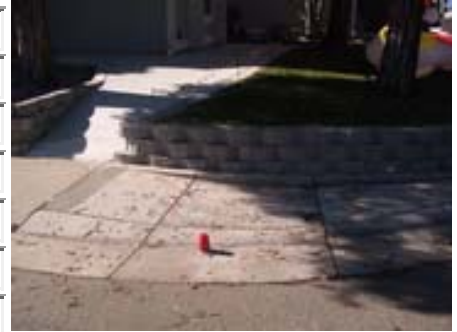
Barrier Type: Detectable Warnings - Truncated Domes

As Built Meas: 1 Quantity: EACH

Description: No truncated domes provided at curb ramp

Bar. Severity: 2 Recommended Cost Estimate: \$0.00 Status:

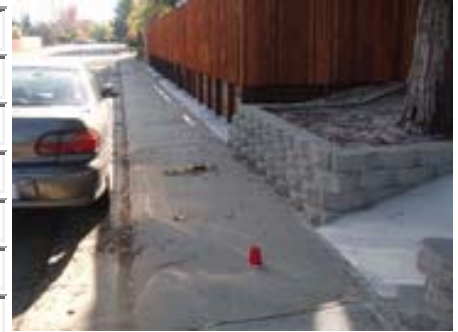
Barrier Type: Cross Slope - Existing (4.1% to 4.9%)

As Built Meas: 196 Quantity: LF

Description: Cross slope exceeds 2.0% (4.1% to 4.9%)

Bar. Severity: 2 Recommended Cost Estimate: \$24,500.00 Status:

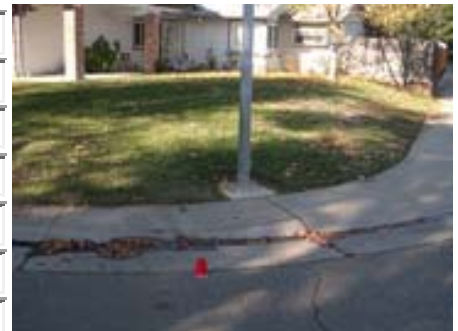
Barrier Type: No Curb Ramp

As Built Meas: 1 Quantity: EACH

Description: No curb cut at corner (intersection)

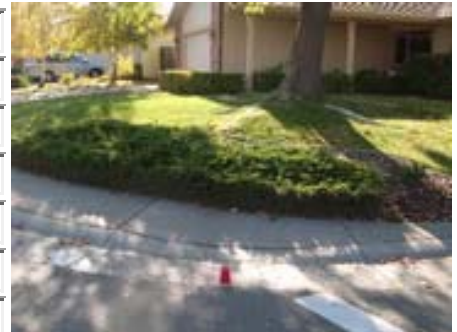
Barrier Type: No Curb Ramp

As Built Meas: 1 Quantity: EACH

Description: No curb cut at corner (intersection)

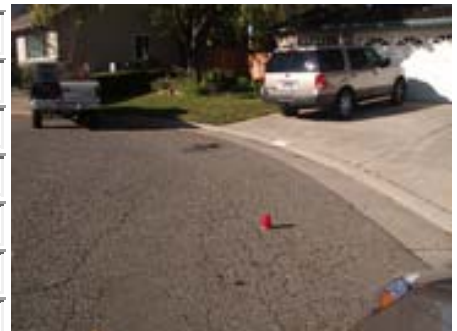
Barrier Type: Shoulder Cross Slope - Existing (4.1% to 4.9%)

As Built Meas: 60 Quantity: LF

Description: Cross slope exceeds 2.0% (4.1% to 4.9%)

Bar. Severity: 2 Recommended Cost Estimate: \$7,500.00 Status:

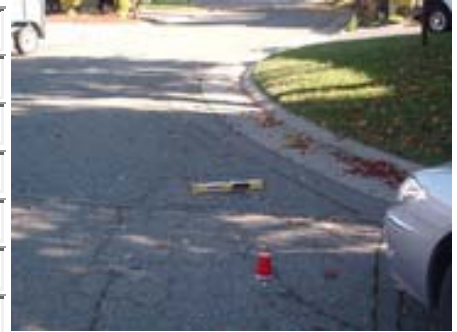
Barrier Type: Shoulder Cross Slope - Existing (3.1% to 4.0%)

As Built Meas: 45 Quantity: LF

Description: Cross slope exceeds 2.0% (3.1% to 4.0%)

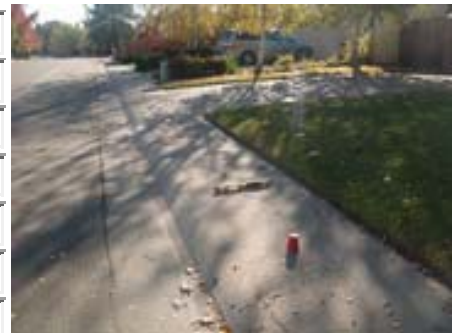
Barrier Type: Cross Slope - Existing (4.1% to 4.9%)

As Built Meas: 269 Quantity: LF

Description: Cross slope exceeds 2.0% (4.1% to 4.9%)

Bar. Severity: 2 Recommended Cost Estimate: \$33,625.00 Status:

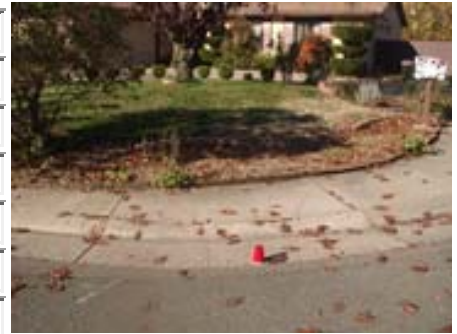
Barrier Type: No Curb Ramp

As Built Meas: 1 Quantity: EACH

Description: No curb cut at corner (intersection)

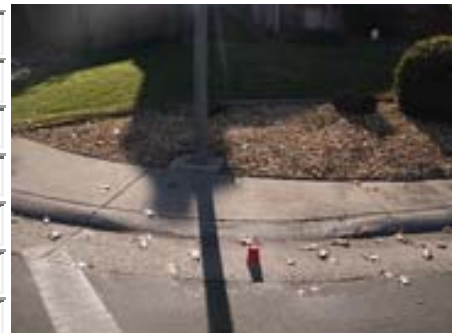
Barrier Type: No Curb Ramp

As Built Meas: 1 Quantity: EACH

Description: No curb cut at corner (intersection)

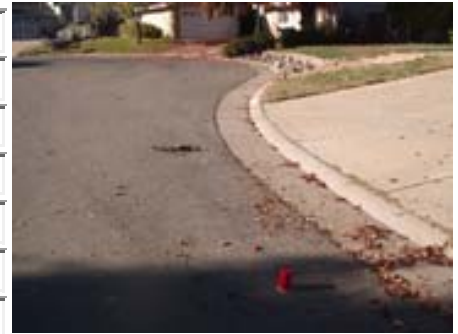
Barrier Type: Shoulder Cross Slope - Existing (5.0% or more)

As Built Meas: 70 Quantity: LF

Description: Cross slope exceeds 2.0% (5.0% or more)

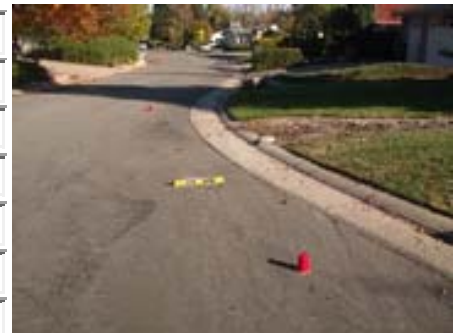
Barrier Type: Shoulder Cross Slope - Existing (5.0% or more)

As Built Meas: 36 Quantity: LF

Description: Cross slope exceeds 2.0% (5.0% or more)

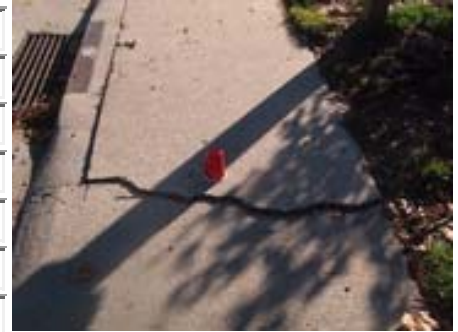
Barrier Type: Abrupt Change in Level - Tree Heaves

As Built Meas: 4 Quantity: LF

Description: Change in level greater than 1/2"

Solution: Grind or repair sidewalk to remove trip hazard

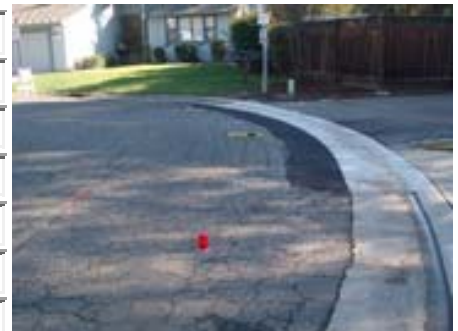
Barrier Type: Shoulder Cross Slope - Existing (4.1% to 4.9%)

As Built Meas: 104 Quantity: LF

Description: Cross slope exceeds 2.0% (4.1% to 4.9%)

Bar. Severity: 2 Recommended Cost Estimate: \$13,000.00 Status:

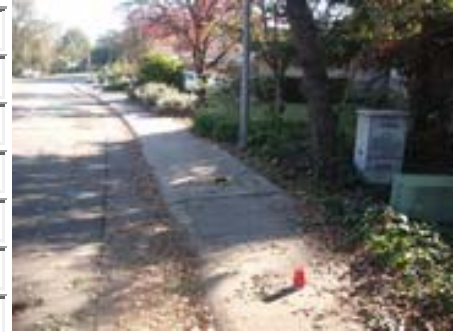
Barrier Type: Cross Slope - Existing (3.1% to 4.0%)

As Built Meas: 187 Quantity: LF

Description: Cross slope exceeds 2.0% (3.1% to 4.0%)
