SZS CONSULTING GROUP

DRAFT ADA TRANSITION PLAN UPDATE
NEIGHBORHOOD AREA 3 CHANT
SEPTEMBER 20, 2011

CITY OF CITRUS HEIGHTS

Citrus Heights Area Three (CHANT)

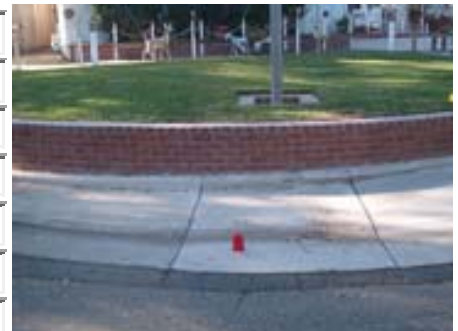
Barrier Type: Detectable Warnings - Truncated Domes

As Built Meas: 1 Quantity: EACH

Description: No truncated domes provided at curb ramp

Bar. Severity: 2 Recommended Cost Estimate: \$1,400.00 Status:

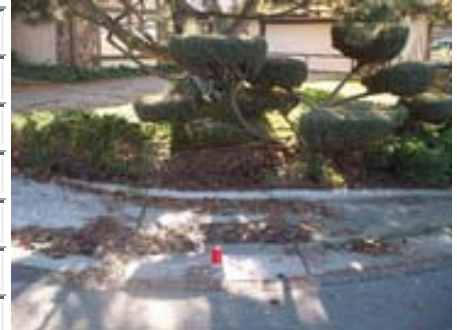
Barrier Type: Detectable Warnings - Truncated Domes

As Built Meas: 1 Quantity: EACH

Description: No truncated domes provided at curb ramp

Bar. Severity: 2 Recommended Cost Estimate: \$1,400.00 Status:

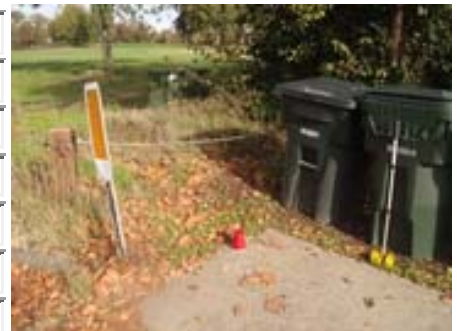
Barrier Type: No Sidewalk - Cane Detectable Barricade

As Built Meas: 5 Quantity: LF

Description: No cane detectable warning on existing barricade

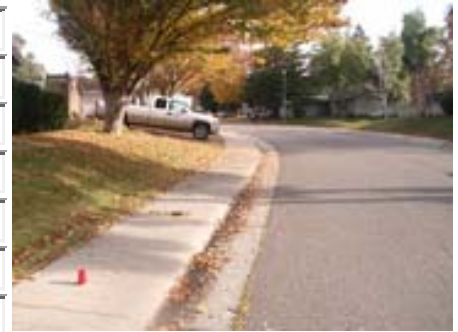
Barrier Type: Cross Slope - Existing (3.1% to 4.0%)

As Built Meas: 604 Quantity: LF

Description: Cross slope exceeds 2.0% (3.1% to 4.0%)

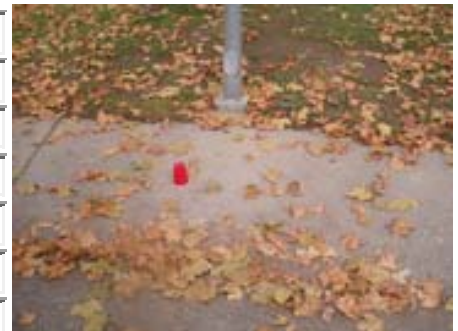
Barrier Type: Elbow in Sidewalk - Cross Slope (5.0% or more)

As Built Meas: 8 Quantity: LF

Description: Cross slope at elbow exceeds 2.0% (5.0% or more)

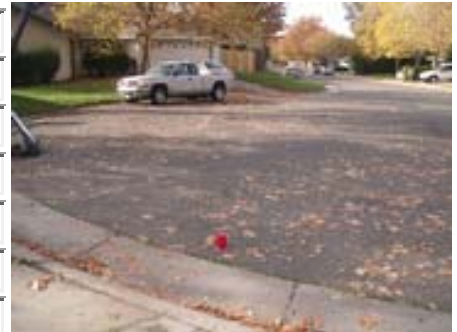
Field Date:	11/30/2010	Report Date:	11/30/2010	Barrier #:	2893
Location:	Big Arrow Ct - East				
X Coordinate:	-121.32326				
Y Coordinate:	38.6909				
Barrier Area:	Sidewalks				
Barrier Type:	Shoulder Cross Slope - Existing (5.0% or more)				
Code Ref:	CBC 1133B.7.1.3 and ADA/ABA 403.3

As Built Meas:	164	Quantity:	LF	
Description:	Cross slope exceeds 2.0% (5.0% or more)			
As Built Desc:	5.4% cross slope			
Solution:	Demolish existing and construct new pedestrian route			
Bar. Severity:	1 Necessary	Cost Estimate:	\$20,500.00	Status:
Implementation Priority:	4	Facility Function:		
Implementation Phase:		Implementation Date:		
Official Responsible:

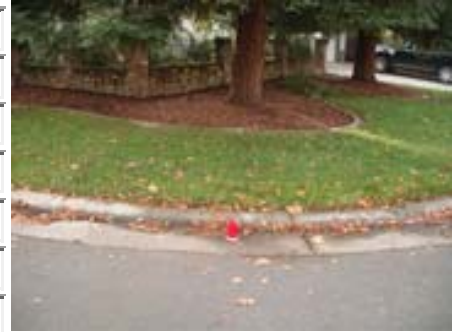
Barrier Type: Detectable Warnings - Truncated Domes

As Built Meas: 1 Quantity: EACH

Description: No truncated domes provided at transition into roadway

Bar. Severity: 2 Recommended Cost Estimate: \$1,400.00 Status:

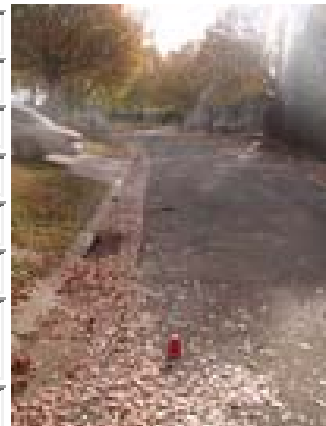
Barrier Type: Shoulder Cross Slope - Existing (5.0% or more)

As Built Meas: 182 Quantity: LF

Description: Cross slope exceeds 2.0% (5.0% or more)

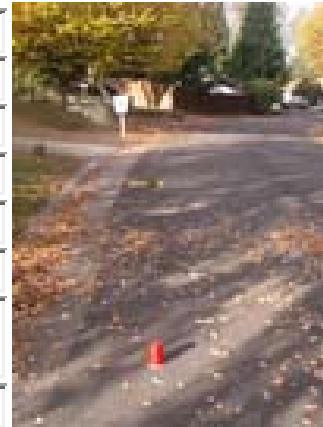
Barrier Type: Shoulder Cross Slope - Existing (5.0% or more)

As Built Meas: 184 Quantity: LF

Description: Cross slope exceeds 2.0% (5.0% or more)

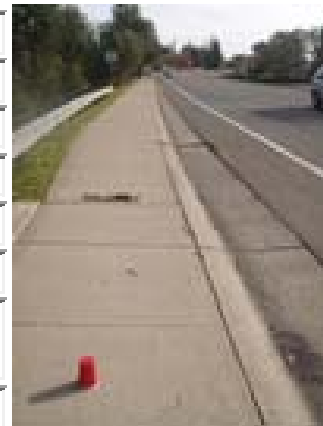
Barrier Type: Cross Slope - Existing (4.1% to 4.9%)

As Built Meas: 585 Quantity: LF

Description: Cross slope exceeds 2.0% (4.1% to 4.9%)

Bar. Severity: 2 Recommended

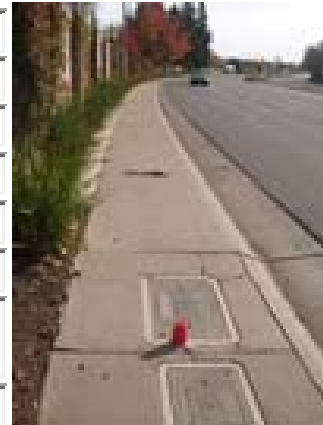
Barrier Type: Cross Slope - Existing (4.1% to 4.9%)

As Built Meas: 578 Quantity: LF

Description: Cross slope exceeds 2.0% (4.1% to 4.9%)

Bar. Severity: 2 Recommended Cost Estimate: \$72,250.00 Status:

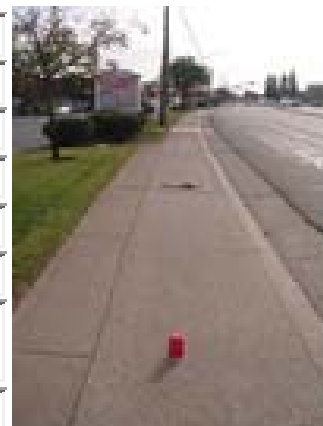
Barrier Type: Cross Slope - Existing (3.1% to 4.0%)

Code Ref: CBC 1133B.7.1.3 and ADA/ABA 403.3

As Built Meas: 140 Quantity: LF

Description: Cross slope exceeds 2.0% (3.1% to 4.0%)

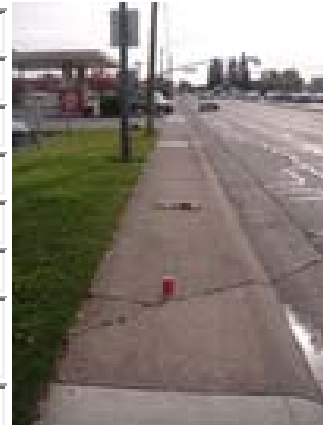
Barrier Type: Cross Slope - Existing (3.1% to 4.0%)

Code Ref: CBC 1133B.7.1.3 and ADA/ABA 403.3

As Built Meas: 62 Quantity: LF

Description: Cross slope exceeds 2.0% (3.1% to 4.0%)

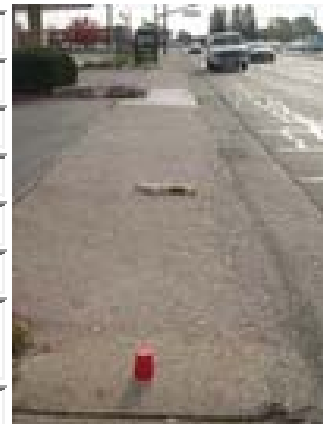
Barrier Type: Driveway - Existing (5.0% or more)

Code Ref: CBC 1133B.7.1.3 and ADA/ABA 403.3

As Built Meas: 40 Quantity: LF

Description: Driveway cross slope exceeds 2.0% (5.0% or more)

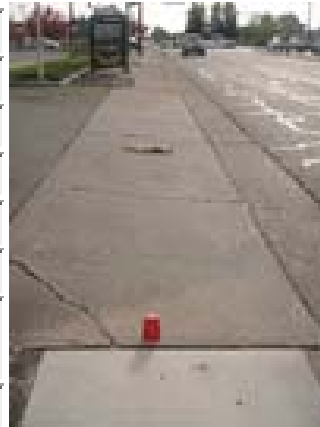
Barrier Type: Driveway - Existing (5.0% or more)

Code Ref: CBC 1133B.7.1.3 and ADA/ABA 403.3

As Built Meas: 40 Quantity: LF

Description: Driveway cross slope exceeds 2.0% (5.0% or more)

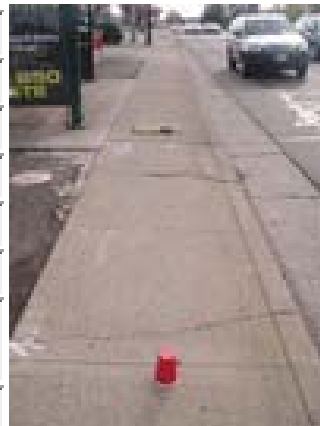
Barrier Type: Cross Slope - Existing (3.1% to 4.0%)

Code Ref: CBC 1133B.7.1.3 and ADA/ABA 403.3

As Built Meas: 51 Quantity: LF

Description: Cross slope exceeds 2.0% (3.1% to 4.0%)

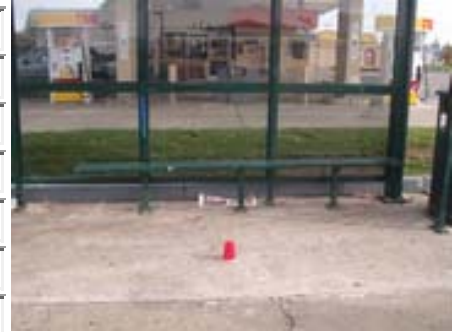
Barrier Type: Bench Seat Depth

Code Ref: ADAAG 4.37.1 and ADA/ABA 903.4

As Built Meas: 1 Quantity: EACH

Description: Bench seat depth not 20" - 24" deep

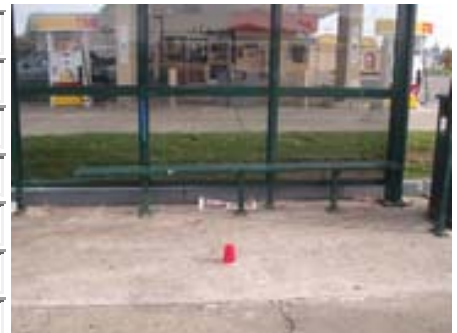
Barrier Type: Bench Back Support

Code Ref: ADAAG 4.37.4 and ADA/ABA 903.4

As Built Meas: 1 Quantity: EACH

Description: Bench has no back support of at least 18" high

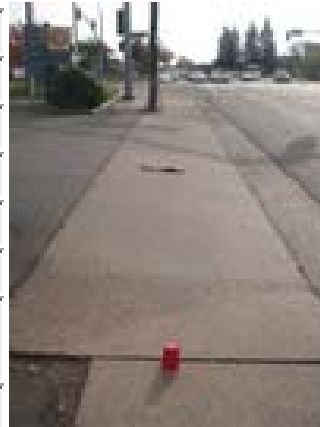
Barrier Type: Driveway - Existing (5.0% or more)

Code Ref: CBC 1133B.7.1.3 and ADA/ABA 403.3

As Built Meas: 39 Quantity: LF

Description: Driveway cross slope exceeds 2.0% (5.0% or more)

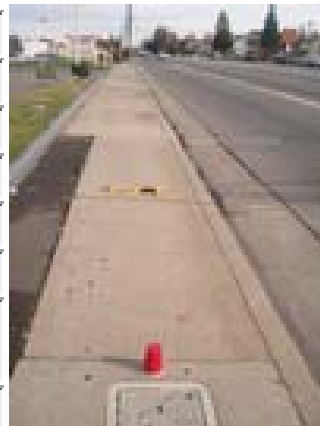
Barrier Type: Cross Slope - Existing (4.1% to 4.9%)

Code Ref: CBC 1133B.7.1.3 and ADA/ABA 403.3

As Built Meas: 50 Quantity: LF

Description: Cross slope exceeds 2.0% (4.1% to 4.9%)

Bar. Severity: 2 Recommended Cost Estimate: \$6,250.00 Status:

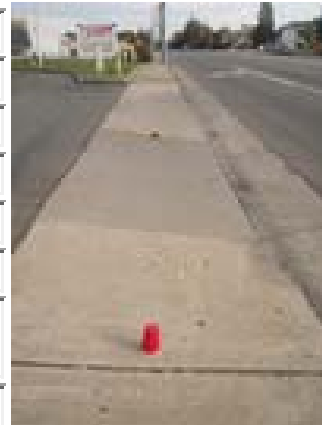
Barrier Type: Driveway - Existing (5.0% or more)

Code Ref: CBC 1133B.7.1.3 and ADA/ABA 403.3

As Built Meas: 41 Quantity: LF

Description: Driveway cross slope exceeds 2.0% (5.0% or more)

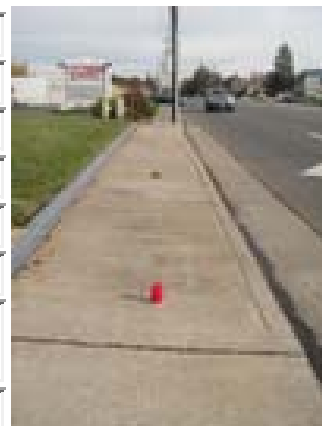
Barrier Type: Cross Slope - Existing (5.0% or more)

Code Ref: CBC 1133B.7.1.3 and ADA/ABA 403.3

As Built Meas: 150 Quantity: LF

Description: Cross slope exceeds 2.0% (5.0% or more)

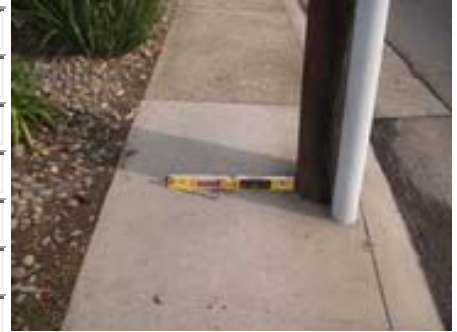
Barrier Type: Clear Width - Existing ($\leq 31"$ or less)

Code Ref: CBC 1133B.7.1

As Built Meas: 4 Quantity: LF

Description: Pedestrian route is not min. 48" wide ($\leq 31"$ or less)

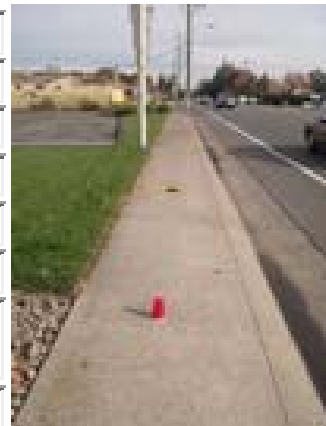
Barrier Type: Cross Slope - Existing (3.1% to 4.0%)

Code Ref: CBC 1133B.7.1.3 and ADA/ABA 403.3

As Built Meas: 124 Quantity: LF

Description: Cross slope exceeds 2.0% (3.1% to 4.0%)

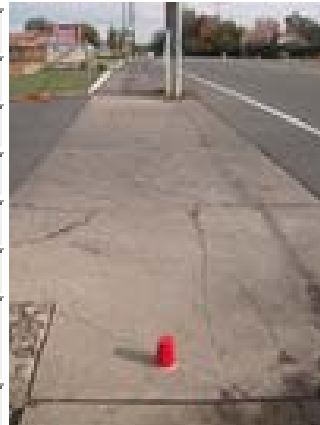
Barrier Type: Driveway - Existing (5.0% or more)

Code Ref: CBC 1133B.7.1.3 and ADA/ABA 403.3

As Built Meas: 44 Quantity: LF

Description: Driveway cross slope exceeds 2.0% (5.0% or more)

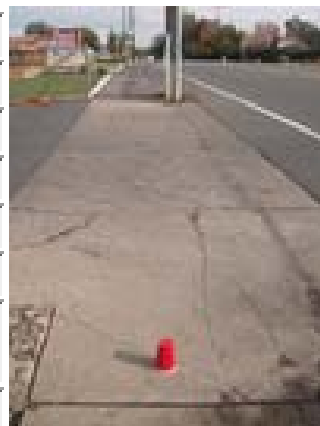
Barrier Type: Surface Condition - Damaged

Code Ref: CBC 1133B.7.1 and ADA/ABA 302.1

As Built Meas: 88 Quantity: LF

Description: Surface is not firm and stable (cracked, broken or loose soil, etc.)

As Built Desc: Cracked concrete

Solution: Repair surface to make firm and stable

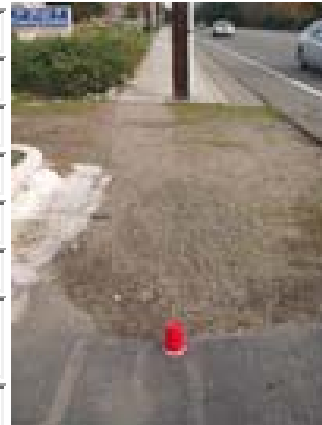
Barrier Type: Surface Condition - Damaged

Code Ref: CBC 1133B.7.1 and ADA/ABA 302.1

As Built Meas: 12 Quantity: LF

Description: Surface is not firm and stable (cracked, broken or loose soil, etc.)

As Built Desc: Loose soil

Solution: Repair surface to make firm and stable

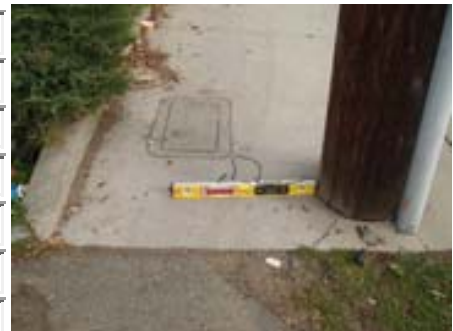
Barrier Type: Clear Width - Existing (32" to 35")

Code Ref: CBC 1133B.7.1

As Built Meas: 4 Quantity: LF

Description: Pedestrian route is not min. 48" wide (32" to 35")

Bar. Severity: 2 Recommended Cost Estimate: \$500.00 Status:

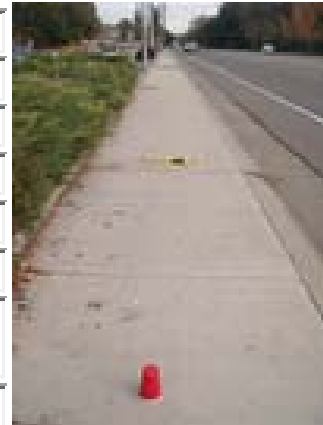
Barrier Type: Cross Slope - Existing (3.1% to 4.0%)

Code Ref: CBC 1133B.7.1.3 and ADA/ABA 403.3

As Built Meas: 83 Quantity: LF

Description: Cross slope exceeds 2.0% (3.1% to 4.0%)

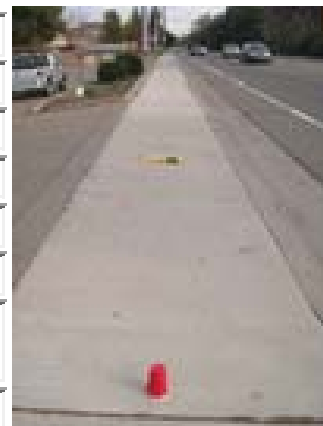
Barrier Type: Driveway - Existing (4.1% to 4.9%)

Code Ref: CBC 1133B.7.1.3 and ADA/ABA 403.3

As Built Meas: 32 Quantity: LF

Description: Driveway cross slope exceeds 2.0% (4.1% to 4.9%)

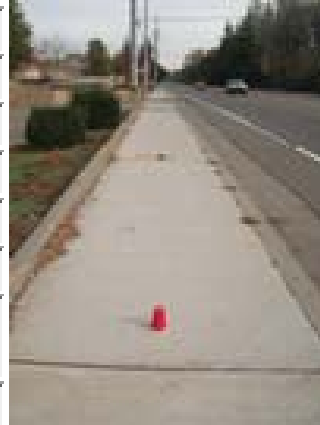
Field Date:	11/30/2010	Report Date:	11/30/2010	Barrier #:	2919
Location:	Auburn Blvd - West				
X Coordinate:	-121.31840				
Y Coordinate:	38.6807				
Barrier Area:	Sidewalks				
Barrier Type:	Cross Slope - Existing (3.1% to 4.0%)				
Code Ref:	CBC 1133B.7.1.3 and ADA/ABA 403.3

As Built Meas:	59	Quantity:	LF
Description:	Cross slope exceeds 2.0% (3.1% to 4.0%)		
As Built Desc:	3.8% cross slope		
Solution:	Demolish existing and construct new route		
Bar. Severity:	3 Hindrance	Cost Estimate:	\$7,375.00
Implementation Priority:	1	Facility Function:	
Implementation Phase:		Implementation Date:	
Official Responsible:			
Notes:

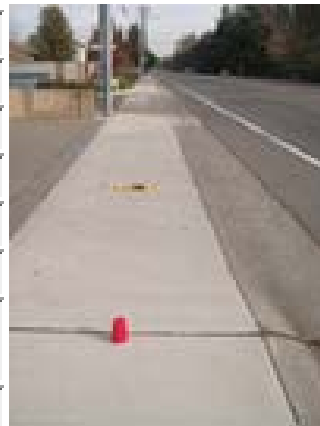
Field Date:	11/30/2010	Report Date:	11/30/2010	Barrier #:	2920
Location:	Auburn Blvd - West				
X Coordinate:	-121.31822				
Y Coordinate:	38.68079				
Barrier Area:	Sidewalks				
Barrier Type:	Driveway - Existing (3.1% to 4.0%)				
Code Ref:	CBC 1133B.7.1.3 and ADA/ABA 403.3

As Built Meas:	42	Quantity:	LF
Description:	Driveway cross slope exceeds 2.0% (3.1% to 4.0%)		
As Built Desc:	3.6% cross slope, 10.6% running slope		
Solution:	Provide min. 48" wide level walkway through driveway		
Bar. Severity:	1 Necessary	Cost Estimate:	\$5,250.00
Implementation Priority:	1	Facility Function:	
Implementation Phase:		Implementation Date:	
Official Responsible:			
Notes:

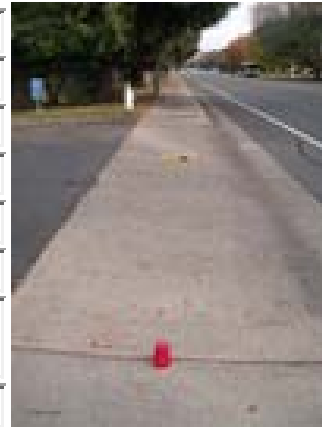
Barrier Type: Driveway - Existing (5.0% or more)

Code Ref: CBC 1133B.7.1.3 and ADA/ABA 403.3

As Built Meas: 40 Quantity: LF

Description: Driveway cross slope exceeds 2.0% (5.0% or more)

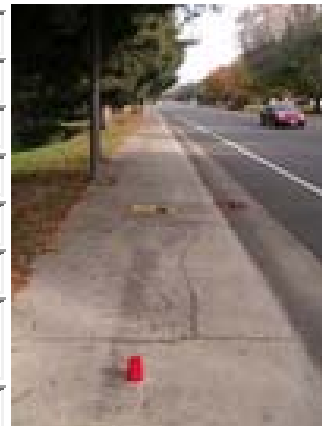
Barrier Type: Cross Slope - Existing (5.0% or more)

Code Ref: CBC 1133B.7.1.3 and ADA/ABA 403.3

As Built Meas: 351 Quantity: LF

Description: Cross slope exceeds 2.0% (5.0% or more)

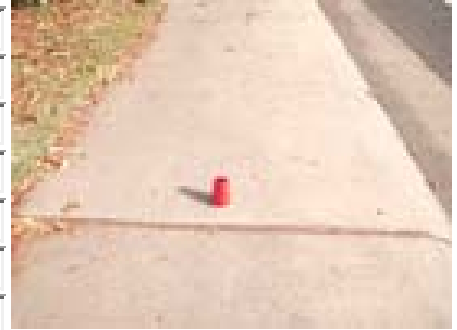
Barrier Type: Abrupt Change in Level - > 1/2"

Code Ref: CBC 1133B.7.1 and ADA/ABA 303.3

As Built Meas: 4 Quantity: LF

Description: Change in level greater than 1/2"

Solution: Grind or repair sidewalk to remove trip hazard

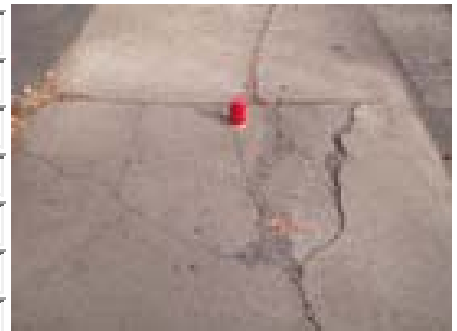
Barrier Type: Surface Condition - Damaged

Code Ref: CBC 1133B.7.1 and ADA/ABA 302.1

As Built Meas: 4 Quantity: LF

Description: Surface is not firm and stable (cracked, broken or loose soil, etc.)

As Built Desc: Cracked concrete

Solution: Repair surface to make firm and stable

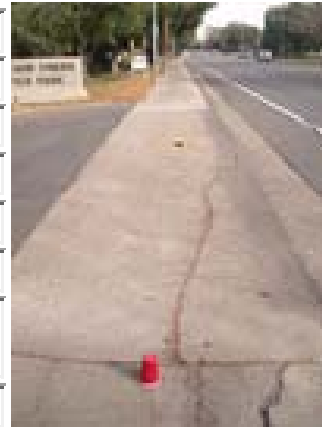
Barrier Type: Driveway - Existing (5.0% or more)

Code Ref: CBC 1133B.7.1.3 and ADA/ABA 403.3

As Built Meas: 40 Quantity: LF

Description: Driveway cross slope exceeds 2.0% (5.0% or more)

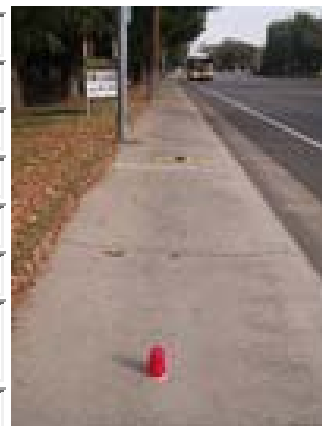
Barrier Type: Cross Slope - Existing (5.0% or more)

Code Ref: CBC 1133B.7.1.3 and ADA/ABA 403.3

As Built Meas: 148 Quantity: LF

Description: Cross slope exceeds 2.0% (5.0% or more)

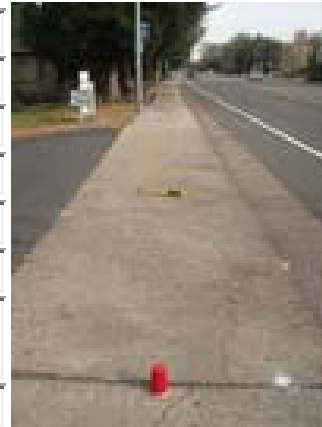
Barrier Type: Driveway - Existing (5.0% or more)

Code Ref: CBC 1133B.7.1.3 and ADA/ABA 403.3

As Built Meas: 39 Quantity: LF

Description: Driveway cross slope exceeds 2.0% (5.0% or more)

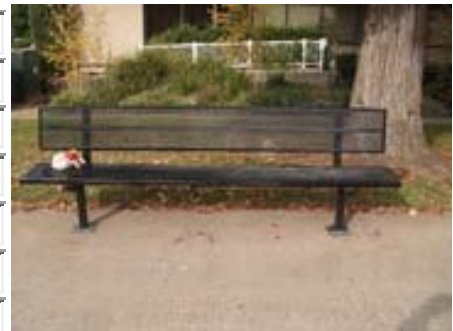
Barrier Type: Bench Seat Depth

Code Ref: ADAAG 4.37.1 and ADA/ABA 903.4

As Built Meas: 1 Quantity: EACH

Description: Bench seat depth not 20" - 24" deep

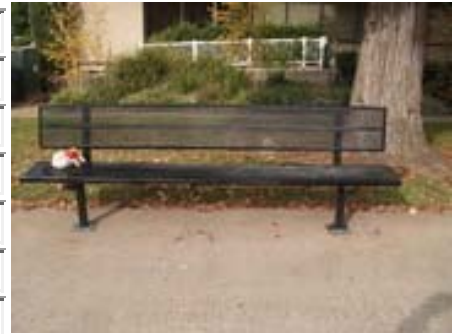
Barrier Type: Bench Back Support

Code Ref: ADAAG 4.37.4 and ADA/ABA 903.4

As Built Meas: 1 Quantity: EACH

Description: Bench has no back support of at least 18" high

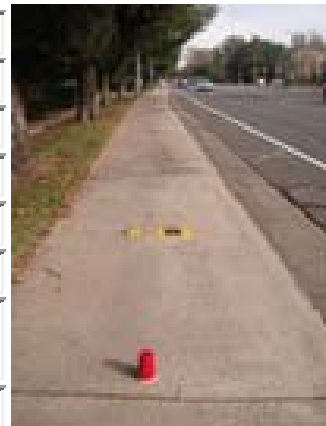
Barrier Type: Cross Slope - Existing (5.0% or more)

Code Ref: CBC 1133B.7.1.3 and ADA/ABA 403.3

As Built Meas: 447 Quantity: LF

Description: Cross slope exceeds 2.0% (5.0% or more)
