**DRAFT ADA TRANSITION PLAN UPDATE  
NEIGHBORHOOD AREA 4 ARCADE CREEK  
SEPTEMBER 20, 2011**

CITY OF CITRUS HEIGHTS

## Arcade Creek Neighborhood Area

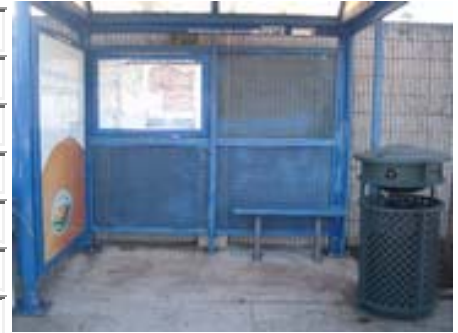
Field Date:	12/1/2010	Report Date:	12/1/2010	Barrier #:	2927A
Location:	Greenback Ln - South				
X Coordinate:	-121.32428				
Y Coordinate:	38.68082				
Barrier Area:	Bus Stops and Shelters				
Barrier Type:	Bench Seat Height				
Code Ref:	ADAAG 4.37.3* and ADA/ABA 903.4

As Built Meas:	1	Quantity:	EACH		
Description:	Bench seat height not between 17" - 19"				
As Built Desc:	20" bench seat height				
Solution:	Provide new compliant bench or remount at compliant height where possible				
Bar. Severity:	3 Hindrance	Cost Estimate:	\$775.00	Status:	
Implementation Priority:	1	Facility Function:			
Implementation Phase:		Implementation Date:			
Official Responsible:

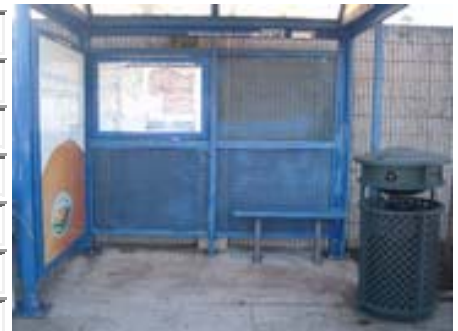
Field Date:	12/1/2010	Report Date:	12/1/2010	Barrier #:	2927B
Location:	Greenback Ln - South				
X Coordinate:	-121.32428				
Y Coordinate:	38.68082				
Barrier Area:	Bus Stops and Shelters				
Barrier Type:	Bench Seat Depth				
Code Ref:	ADAAG 4.37.1 and ADA/ABA 903.4

As Built Meas:	1	Quantity:	EACH		
Description:	Bench seat depth not 20" - 24" deep				
As Built Desc:	9" bench seat depth				
Solution:	Provide min. 1 accessible bench at bench stop				
Bar. Severity:	3 Hindrance	Cost Estimate:	\$0.00	Status:	
Implementation Priority:	1	Facility Function:			
Implementation Phase:		Implementation Date:			
Official Responsible:

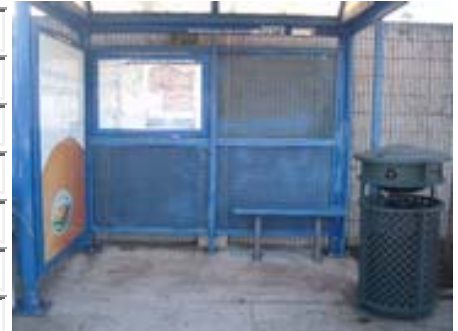
Field Date:	12/1/2010	Report Date:	12/1/2010	Barrier #:	2927C
Location:	Greenback Ln - South				
X Coordinate:	-121.32428				
Y Coordinate:	38.68082				
Barrier Area:	Bus Stops and Shelters				
Barrier Type:	Bench Back Support				
Code Ref:	ADAAG 4.37.4 and ADA/ABA 903.4

As Built Meas:	1	Quantity:	EACH	
Description:	Bench has no back support of at least 18" high			
As Built Desc:	No back support provided			
Solution:	Provide min. 1 accessible bench at bench stop or shelter			
Bar. Severity:	3 Hindrance	Cost Estimate:	\$0.00	Status:
Implementation Priority:	1	Facility Function:		
Implementation Phase:		Implementation Date:		
Official Responsible:

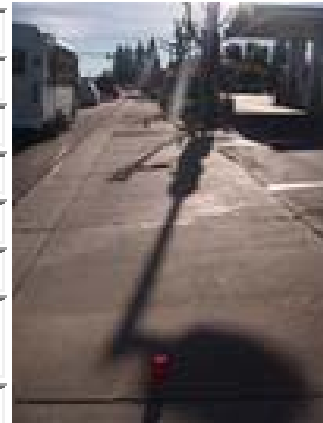
Field Date:	12/1/2010	Report Date:	12/1/2010	Barrier #:	2928
Location:	Greenback Ln - South				
X Coordinate:	-121.32139				
Y Coordinate:	38.67949				
Barrier Area:	Sidewalks				
Barrier Type:	Driveway - Existing (3.1% to 4.0%)				
Code Ref:	CBC 1133B.7.1.3 and ADA/ABA 403.3

As Built Meas:	40	Quantity:	LF	
Description:	Driveway cross slope exceeds 2.0% (3.1% to 4.0%)			
As Built Desc:	3.8% cross slope			
Solution:	Provide min. 48" wide level walkway through driveway			
Bar. Severity:	2 Recommended	Cost Estimate:	\$5,000.00	Status:
Implementation Priority:	1	Facility Function:		
Implementation Phase:		Implementation Date:		
Official Responsible:

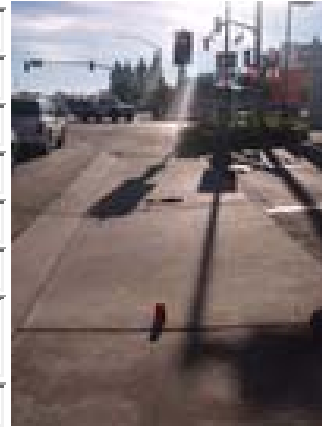
Field Date:	12/1/2010	Report Date:	12/1/2010	Barrier #:	2929
Location:	Greenback Ln - South				
X Coordinate:	-121.32111				
Y Coordinate:	38.67917				
Barrier Area:	Sidewalks				
Barrier Type:	Driveway - Existing (3.1% to 4.0%)				
Code Ref:	CBC 1133B.7.1.3 and ADA/ABA 403.3

As Built Meas:	40	Quantity:	LF	
Description:	Driveway cross slope exceeds 2.0% (3.1% to 4.0%)			
As Built Desc:	4.0% cross slope			
Solution:	Provide min. 48" wide level walkway through driveway			
Bar. Severity:	2 Recommended	Cost Estimate:	\$5,000.00	Status:
Implementation Priority:	1	Facility Function:		
Implementation Phase:		Implementation Date:		
Official Responsible:

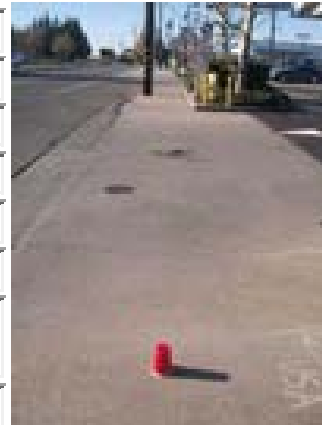
Field Date:	12/1/2010	Report Date:	12/1/2010	Barrier #:	2930
Location:	Auburn Blvd - West				
X Coordinate:	-121.32109				
Y Coordinate:	38.67899				
Barrier Area:	Sidewalks				
Barrier Type:	Driveway - Existing (2.1% to 3.0%)				
Code Ref:	CBC 1133B.7.1.3 and ADA/ABA 403.3

As Built Meas:	39	Quantity:	LF	
Description:	Driveway cross slope exceeds 2.0% (2.1% to 3.0%)			
As Built Desc:	2.7% cross slope, 10.1% running slope			
Solution:	Provide min. 48" wide level walkway through driveway			
Bar. Severity:	1 Necessary	Cost Estimate:	\$4,875.00	Status:
Implementation Priority:	1	Facility Function:		
Implementation Phase:		Implementation Date:		
Official Responsible:

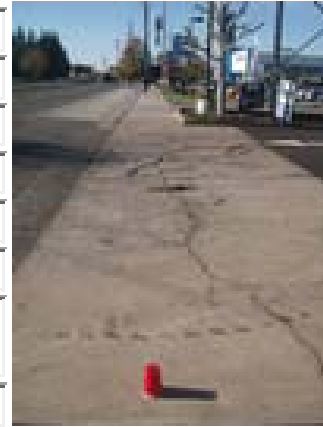
Field Date:	12/1/2010	Report Date:	12/1/2010	Barrier #:	2931A
Location:	Auburn Blvd - West				
X Coordinate:	-121.32132				
Y Coordinate:	38.67884				
Barrier Area:	Sidewalks				
Barrier Type:	Driveway - Existing (3.1% to 4.0%)				
Code Ref:	CBC 1133B.7.1.3 and ADA/ABA 403.3

As Built Meas:	41	Quantity:	LF		
Description:	Driveway cross slope exceeds 2.0% (3.1% to 4.0%)				
As Built Desc:	3.4% cross slope, 8.5% running slope				
Solution:	Provide min. 48" wide level walkway through driveway				
Bar. Severity:	1 Necessary	Cost Estimate:	\$5,125.00	Status:	
Implementation Priority:	1	Facility Function:			
Implementation Phase:		Implementation Date:			
Official Responsible:

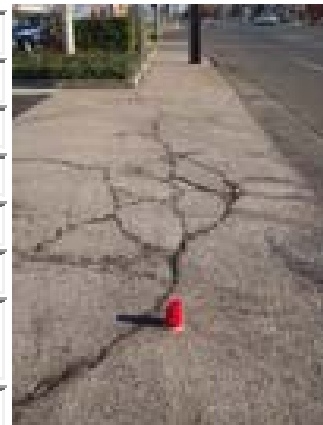
Field Date:	12/1/2010	Report Date:	12/1/2010	Barrier #:	2931B
Location:	Auburn Blvd - West				
X Coordinate:	-121.32132				
Y Coordinate:	38.67882				
Barrier Area:	Sidewalks				
Barrier Type:	Surface Condition - Damaged				
Code Ref:	CBC 1133B.7.1 and ADA/ABA 302.1

As Built Meas:	10	Quantity:	LF		
Description:	Surface is not firm and stable (cracked, broken or loose soil, etc.)				
As Built Desc:	Cracked concrete				
Solution:	Repair surface to make firm and stable				
Bar. Severity:	1 Necessary	Cost Estimate:	\$1,250.00	Status:	
Implementation Priority:	1	Facility Function:			
Implementation Phase:		Implementation Date:			
Official Responsible:

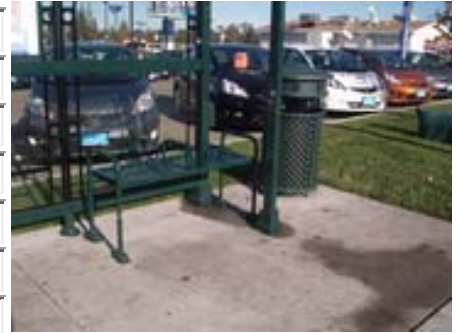
Field Date:	12/1/2010	Report Date:	12/1/2010	Barrier #:	2932A
Location:	Auburn Blvd - West				
X Coordinate:	-121.32171				
Y Coordinate:	38.67865				
Barrier Area:	Bus Stops and Shelters				
Barrier Type:	Bench Seat Height				
Code Ref:	ADAAG 4.37.3* and ADA/ABA 903.4

As Built Meas:	1	Quantity:	EACH
Description:	Bench seat height not between 17" - 19"		
As Built Desc:	21" bench seat height		
Solution:	Provide new compliant bench or remount at compliant height where possible		
Bar. Severity:	3 Hindrance	Cost Estimate:	\$775.00
Implementation Priority:	1	Facility Function:	
Implementation Phase:		Implementation Date:	
Official Responsible:

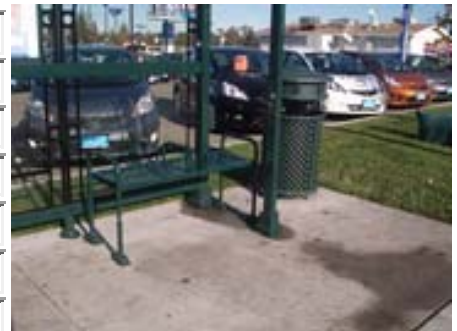
Field Date:	12/1/2010	Report Date:	12/1/2010	Barrier #:	2932B
Location:	Auburn Blvd - West				
X Coordinate:	-121.32171				
Y Coordinate:	38.67865				
Barrier Area:	Bus Stops and Shelters				
Barrier Type:	Bench Seat Depth				
Code Ref:	ADAAG 4.37.1 and ADA/ABA 903.4

As Built Meas:	1	Quantity:	EACH
Description:	Bench seat depth not 20" - 24" deep		
As Built Desc:	15" bench seat depth		
Solution:	Provide min. 1 accessible bench at bench stop		
Bar. Severity:	3 Hindrance	Cost Estimate:	\$0.00
Implementation Priority:	1	Facility Function:	
Implementation Phase:		Implementation Date:	
Official Responsible:

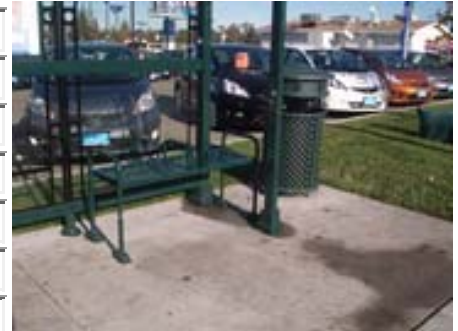
Field Date:	12/1/2010	Report Date:	12/1/2010	Barrier #:	2932C
Location:	Auburn Blvd - West				
X Coordinate:	-121.32171				
Y Coordinate:	38.67865				
Barrier Area:	Bus Stops and Shelters				
Barrier Type:	Bench Back Support				
Code Ref:	ADAAG 4.37.4 and ADA/ABA 903.4

As Built Meas:	1	Quantity:	EACH	
Description:	Bench has no back support of at least 18" high			
As Built Desc:	No back support provided			
Solution:	Provide min. 1 accessible bench at bench stop or shelter			
Bar. Severity:	3 Hindrance	Cost Estimate:	\$0.00	Status:
Implementation Priority:	1	Facility Function:		
Implementation Phase:		Implementation Date:		
Official Responsible:

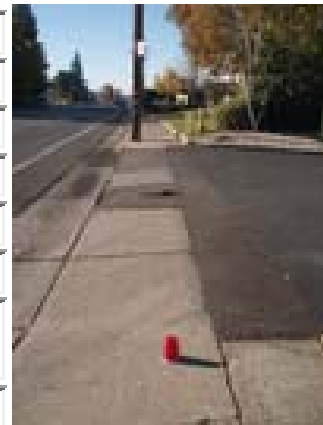
Field Date:	12/1/2010	Report Date:	12/1/2010	Barrier #:	2933
Location:	Auburn Blvd - West				
X Coordinate:	-121.32269				
Y Coordinate:	38.6778				
Barrier Area:	Sidewalks				
Barrier Type:	Driveway - Existing (4.1% to 4.9%)				
Code Ref:	CBC 1133B.7.1.3 and ADA/ABA 403.3

As Built Meas:	36	Quantity:	LF	
Description:	Driveway cross slope exceeds 2.0% (4.1% to 4.9%)			
As Built Desc:	4.1% cross slope			
Solution:	Provide min. 48" wide level walkway through driveway			
Bar. Severity:	3 Hinderance	Cost Estimate:	\$4,500.00	Status:
Implementation Priority:	1	Facility Function:		
Implementation Phase:		Implementation Date:		
Official Responsible:

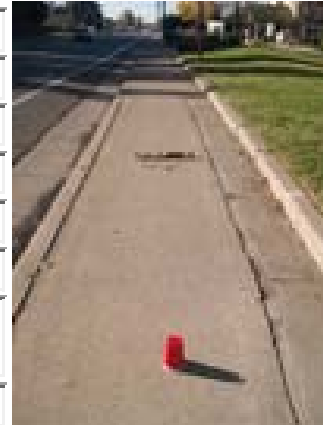
Field Date:	12/1/2010	Report Date:	12/1/2010	Barrier #:	2934
Location:	Auburn Blvd - West				
X Coordinate:	-121.32277				
Y Coordinate:	38.67776				
Barrier Area:	Sidewalks				
Barrier Type:	Cross Slope - Existing (3.1% to 4.0%)				
Code Ref:	CBC 1133B.7.1.3 and ADA/ABA 403.3

As Built Meas:	83	Quantity:	LF	
Description:	Cross slope exceeds 2.0% (3.1% to 4.0%)			
As Built Desc:	3.3% cross slope			
Solution:	Demolish existing and construct new route			
Bar. Severity:	3 Hinderance	Cost Estimate:	\$10,375.00	Status:
Implementation Priority:	1	Facility Function:		
Implementation Phase:		Implementation Date:		
Official Responsible:

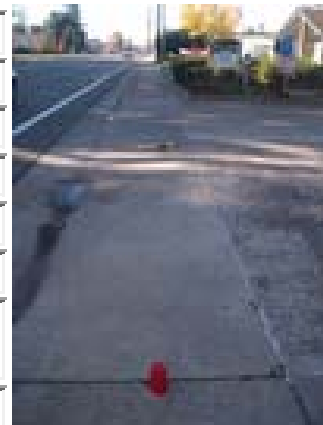
Field Date:	12/1/2010	Report Date:	12/1/2010	Barrier #:	2935
Location:	Auburn Blvd - West				
X Coordinate:	-121.32301				
Y Coordinate:	38.67756				
Barrier Area:	Sidewalks				
Barrier Type:	Driveway - Existing (5.0% or more)				
Code Ref:	CBC 1133B.7.1.3 and ADA/ABA 403.3

As Built Meas:	37	Quantity:	LF	
Description:	Driveway cross slope exceeds 2.0% (5.0% or more)			
As Built Desc:	7.3% cross slope			
Solution:	Provide min. 48" wide level walkway through driveway			
Bar. Severity:	4 Low Severity	Cost Estimate:	\$4,625.00	Status:
Implementation Priority:	1	Facility Function:		
Implementation Phase:		Implementation Date:		
Official Responsible:

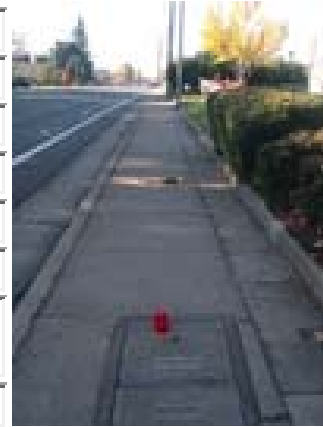
Field Date:	12/1/2010	Report Date:	12/1/2010	Barrier #:	2936
Location:	Auburn Blvd - West				
X Coordinate:	-121.32306				
Y Coordinate:	38.67749				
Barrier Area:	Sidewalks				
Barrier Type:	Cross Slope - Existing (3.1% to 4.0%)				
Code Ref:	CBC 1133B.7.1.3 and ADA/ABA 403.3

As Built Meas:	54	Quantity:	LF	
Description:	Cross slope exceeds 2.0% (3.1% to 4.0%)			
As Built Desc:	3.3% cross slope			
Solution:	Demolish existing and construct new route			
Bar. Severity:	3 Hinderance	Cost Estimate:	\$6,750.00	Status:
Implementation Priority:	1	Facility Function:		
Implementation Phase:		Implementation Date:		
Official Responsible:

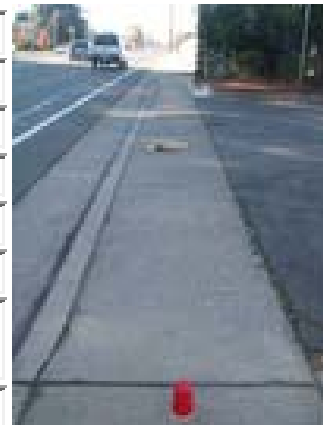
Field Date:	12/1/2010	Report Date:	12/1/2010	Barrier #:	2937
Location:	Auburn Blvd - West				
X Coordinate:	-121.32332				
Y Coordinate:	38.67727				
Barrier Area:	Sidewalks				
Barrier Type:	Driveway - Existing (5.0% or more)				
Code Ref:	CBC 1133B.7.1.3 and ADA/ABA 403.3

As Built Meas:	37	Quantity:	LF	
Description:	Driveway cross slope exceeds 2.0% (5.0% or more)			
As Built Desc:	7.3% cross slope			
Solution:	Provide min. 48" wide level walkway through driveway			
Bar. Severity:	4 Low Severity	Cost Estimate:	\$4,625.00	Status:
Implementation Priority:	1	Facility Function:		
Implementation Phase:		Implementation Date:		
Official Responsible:

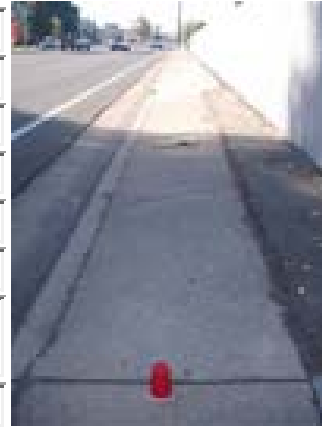
Field Date:	12/1/2010	Report Date:	12/1/2010	Barrier #:	2938
Location:	Auburn Blvd - West				
X Coordinate:	-121.32372				
Y Coordinate:	38.67691				
Barrier Area:	Sidewalks				
Barrier Type:	Driveway - Existing (5.0% or more)				
Code Ref:	CBC 1133B.7.1.3 and ADA/ABA 403.3

As Built Meas:	38	Quantity:	LF	
Description:	Driveway cross slope exceeds 2.0% (5.0% or more)			
As Built Desc:	8.0% cross slope			
Solution:	Provide min. 48" wide level walkway through driveway			
Bar. Severity:	4 Low Severity	Cost Estimate:	\$4,750.00	Status:
Implementation Priority:	1	Facility Function:		
Implementation Phase:		Implementation Date:		
Official Responsible:

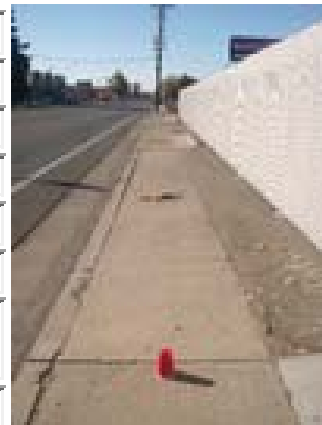
Field Date:	12/1/2010	Report Date:	12/1/2010	Barrier #:	2939
Location:	Auburn Blvd - West				
X Coordinate:	-121.32378				
Y Coordinate:	38.67685				
Barrier Area:	Sidewalks				
Barrier Type:	Driveway - Existing (5.0% or more)				
Code Ref:	CBC 1133B.7.1.3 and ADA/ABA 403.3

As Built Meas:	38	Quantity:	LF	
Description:	Driveway cross slope exceeds 2.0% (5.0% or more)			
As Built Desc:	8.0% cross slope			
Solution:	Provide min. 48" wide level walkway through driveway			
Bar. Severity:	4 Low Severity	Cost Estimate:	\$4,750.00	Status:
Implementation Priority:	1	Facility Function:		
Implementation Phase:		Implementation Date:		
Official Responsible:

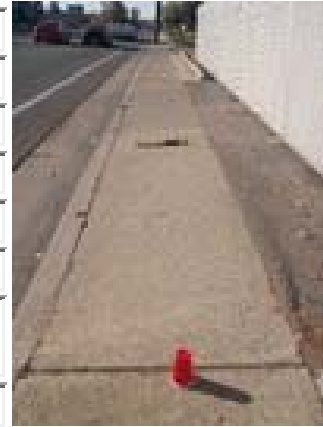
Field Date:	12/1/2010	Report Date:	12/1/2010	Barrier #:	2940
Location:	Auburn Blvd - West				
X Coordinate:	-121.32385				
Y Coordinate:	38.67679				
Barrier Area:	Sidewalks				
Barrier Type:	Driveway - Existing (5.0% or more)				
Code Ref:	CBC 1133B.7.1.3 and ADA/ABA 403.3

As Built Meas:	36	Quantity:	LF	
Description:	Driveway cross slope exceeds 2.0% (5.0% or more)			
As Built Desc:	6.9% cross slope			
Solution:	Provide min. 48" wide level walkway through driveway			
Bar. Severity:	4 Low Severity	Cost Estimate:	\$4,500.00	Status:
Implementation Priority:	1	Facility Function:		
Implementation Phase:		Implementation Date:		
Official Responsible:

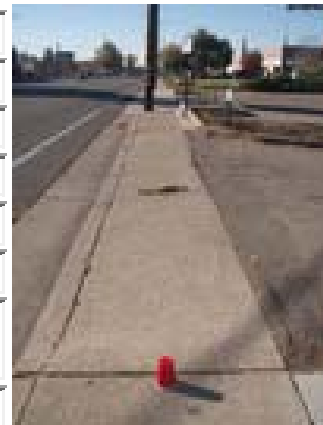
Field Date:	12/1/2010	Report Date:	12/1/2010	Barrier #:	2941
Location:	Auburn Blvd - West				
X Coordinate:	-121.324				
Y Coordinate:	38.67662				
Barrier Area:	Sidewalks				
Barrier Type:	Driveway - Existing (5.0% or more)				
Code Ref:	CBC 1133B.7.1.3 and ADA/ABA 403.3

As Built Meas:	33	Quantity:	LF	
Description:	Driveway cross slope exceeds 2.0% (5.0% or more)			
As Built Desc:	6.3% cross slope			
Solution:	Provide min. 48" wide level walkway through driveway			
Bar. Severity:	4 Low Severity	Cost Estimate:	\$4,125.00	Status:
Implementation Priority:	1	Facility Function:		
Implementation Phase:		Implementation Date:		
Official Responsible:

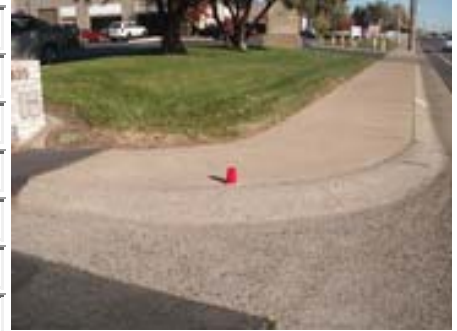
Field Date:	12/1/2010	Report Date:	12/1/2010	Barrier #:	2942
Location:	Auburn Blvd and Imperial Wy - Corner A				
X Coordinate:	-121.32509				
Y Coordinate:	38.67565				
Barrier Area:	Curb Ramps				
Barrier Type:	No Curb Ramp				
Code Ref:	CBC 1127B.5.1 and ADA/ABA 402.2

As Built Meas:	1	Quantity:	EACH	
Description:	No curb cut at corner (intersection)			
As Built Desc:	No curb ramp at corner			
Solution:	Demolish existing and construct curb cut			
Bar. Severity:	1 Necessary	Cost Estimate:	\$2,500.00	Status:
Implementation Priority:	1	Facility Function:		
Implementation Phase:		Implementation Date:		
Official Responsible:

Notes: Two - way intersection corners A,D. Corner D compliant

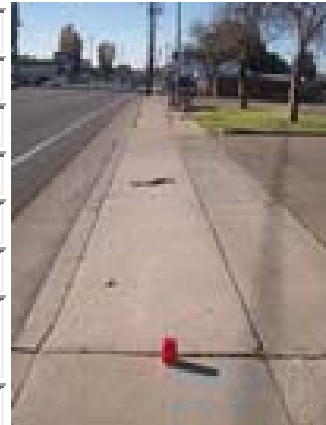
Field Date:	12/1/2010	Report Date:	12/1/2010	Barrier #:	2943
Location:	Auburn Blvd - West				
X Coordinate:	-121.32549				
Y Coordinate:	38.67535				
Barrier Area:	Sidewalks				
Barrier Type:	Driveway - Existing (5.0% or more)				
Code Ref:	CBC 1133B.7.1.3 and ADA/ABA 403.3

As Built Meas:	43	Quantity:	LF	
Description:	Driveway cross slope exceeds 2.0% (5.0% or more)			
As Built Desc:	8.8% cross slope			
Solution:	Provide min. 48" wide level walkway through driveway			
Bar. Severity:	4 Low Severity	Cost Estimate:	\$5,375.00	Status:
Implementation Priority:	1	Facility Function:		
Implementation Phase:		Implementation Date:		
Official Responsible:

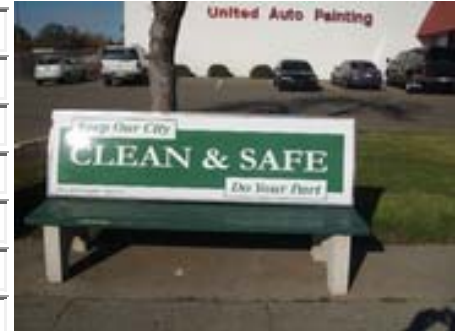
Field Date:	12/1/2010	Report Date:	12/1/2010	Barrier #:	2944
Location:	Auburn Blvd - West				
X Coordinate:	-121.32561				
Y Coordinate:	38.67522				
Barrier Area:	Bus Stops and Shelters				
Barrier Type:	Bench Seat Depth				
Code Ref:	ADAAG 4.37.1 and ADA/ABA 903.4

As Built Meas:	1	Quantity:	EACH
Description:	Bench seat depth not 20" - 24" deep		
As Built Desc:	16" bench seat depth		
Solution:	Provide min. 1 accessible bench at bench stop		
Bar. Severity:	3 Hindrance	Cost Estimate:	\$775.00
Implementation Priority:	1	Facility Function:	
Implementation Phase:		Implementation Date:	
Official Responsible:			
Notes:

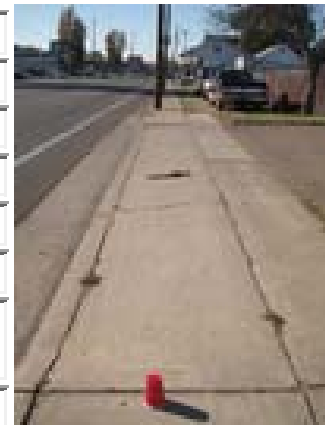
Field Date:	12/1/2010	Report Date:	12/1/2010	Barrier #:	2945
Location:	Auburn Blvd - West				
X Coordinate:	-121.32572				
Y Coordinate:	38.67514				
Barrier Area:	Sidewalks				
Barrier Type:	Cross Slope - Existing (5.0% or more)				
Code Ref:	CBC 1133B.7.1.3 and ADA/ABA 403.3

As Built Meas:	37	Quantity:	LF
Description:	Cross slope exceeds 2.0% (5.0% or more)		
As Built Desc:	7.8% cross slope		
Solution:	Demolish existing and construct new route		
Bar. Severity:	1 Necessary	Cost Estimate:	\$4,625.00
Implementation Priority:	1	Facility Function:	
Implementation Phase:		Implementation Date:	
Official Responsible:			
Notes:

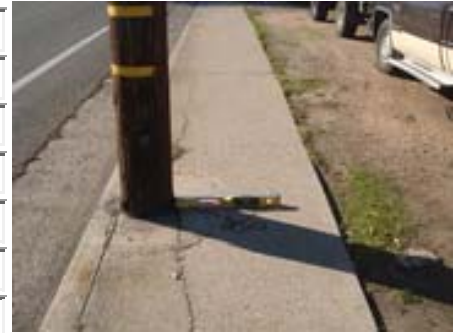
Field Date:	12/1/2010	Report Date:	12/1/2010	Barrier #:	2946
Location:	Auburn Blvd - West				
X Coordinate:	-121.32578				
Y Coordinate:	38.67508				
Barrier Area:	Sidewalks				
Barrier Type:	Clear Width - Existing ( $\leq 31"$ or less)				
Code Ref:	CBC 1133B.7.1

As Built Meas:	4	Quantity:	LF		
Description:	Pedestrian route is not min. 48" wide ( $\leq 31"$ or less)				
As Built Desc:	31" clear width due to pole				
Solution:	Demolish existing and construct new route				
Bar. Severity:	1 Necessary	Cost Estimate:	\$500.00	Status:	
Implementation Priority:	1	Facility Function:			
Implementation Phase:		Implementation Date:			
Official Responsible:

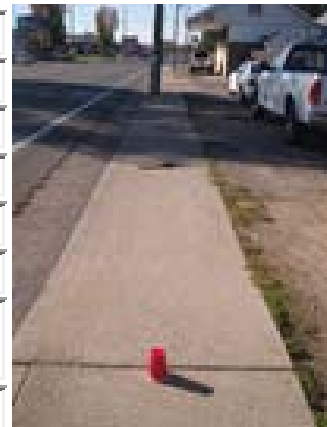
Field Date:	12/1/2010	Report Date:	12/1/2010	Barrier #:	2947
Location:	Auburn Blvd - West				
X Coordinate:	-121.32587				
Y Coordinate:	38.675				
Barrier Area:	Sidewalks				
Barrier Type:	Driveway - Existing (4.1% to 4.9%)				
Code Ref:	CBC 1133B.7.1.3 and ADA/ABA 403.3

As Built Meas:	38	Quantity:	LF		
Description:	Driveway cross slope exceeds 2.0% (4.1% to 4.9%)				
As Built Desc:	4.5% cross slope				
Solution:	Provide min. 48" wide level walkway through driveway				
Bar. Severity:	3 Hinderance	Cost Estimate:	\$4,750.00	Status:	
Implementation Priority:	1	Facility Function:			
Implementation Phase:		Implementation Date:			
Official Responsible:

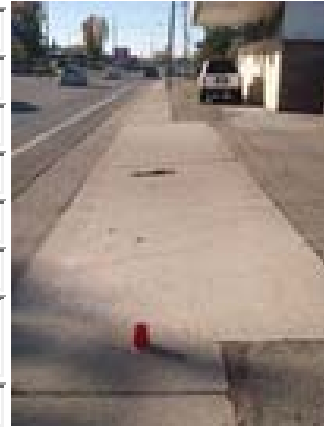
Field Date:	12/1/2010	Report Date:	12/1/2010	Barrier #:	2948
Location:	Auburn Blvd - West				
X Coordinate:	-121.32601				
Y Coordinate:	38.67489				
Barrier Area:	Sidewalks				
Barrier Type:	Driveway - Existing (5.0% or more)				
Code Ref:	CBC 1133B.7.1.3 and ADA/ABA 403.3

As Built Meas:	36	Quantity:	LF	
Description:	Driveway cross slope exceeds 2.0% (5.0% or more)			
As Built Desc:	5.3% cross slope			
Solution:	Provide min. 48" wide level walkway through driveway			
Bar. Severity:	4 Low Severity	Cost Estimate:	\$4,500.00	Status:
Implementation Priority:	1	Facility Function:		
Implementation Phase:		Implementation Date:		
Official Responsible:

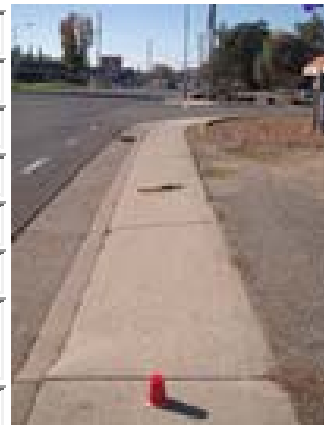
Field Date:	12/1/2010	Report Date:	12/1/2010	Barrier #:	2949
Location:	Auburn Blvd - West				
X Coordinate:	-121.32627				
Y Coordinate:	38.67468				
Barrier Area:	Sidewalks				
Barrier Type:	Driveway - Existing (5.0% or more)				
Code Ref:	CBC 1133B.7.1.3 and ADA/ABA 403.3

As Built Meas:	36	Quantity:	LF	
Description:	Driveway cross slope exceeds 2.0% (5.0% or more)			
As Built Desc:	8.8% cross slope			
Solution:	Provide min. 48" wide level walkway through driveway			
Bar. Severity:	4 Low Severity	Cost Estimate:	\$4,500.00	Status:
Implementation Priority:	1	Facility Function:		
Implementation Phase:		Implementation Date:		
Official Responsible:

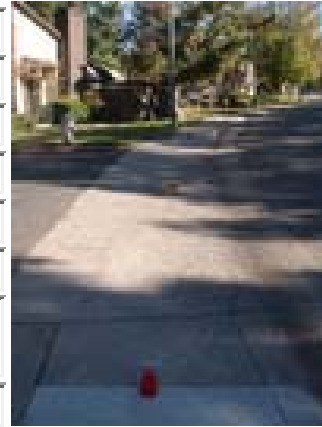
Field Date:	12/1/2010	Report Date:	12/1/2010	Barrier #:	2950
Location:	Bremen Dr - West				
X Coordinate:	-121.31615				
Y Coordinate:	38.67945				
Barrier Area:	Sidewalks				
Barrier Type:	Cross Slope - Existing (3.1% to 4.0%)				
Code Ref:	CBC 1133B.7.1.3 and ADA/ABA 403.3

As Built Meas:	43	Quantity:	LF	
Description:	Cross slope exceeds 2.0% (3.1% to 4.0%)			
As Built Desc:	3.8% cross slope			
Solution:	Demolish existing and construct new route			
Bar. Severity:	3 Hinderance	Cost Estimate:	\$5,375.00	Status:
Implementation Priority:	4	Facility Function:		
Implementation Phase:		Implementation Date:		
Official Responsible:

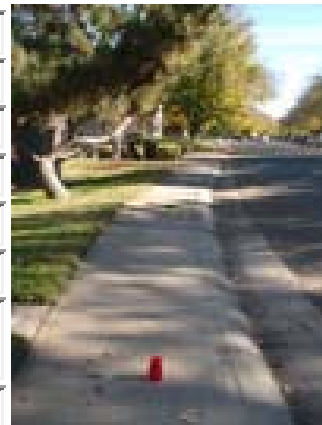
Field Date:	12/1/2010	Report Date:	12/1/2010	Barrier #:	2951
Location:	Bremen Dr - West				
X Coordinate:	-121.31592				
Y Coordinate:	38.67952				
Barrier Area:	Sidewalks				
Barrier Type:	Cross Slope - Existing (3.1% to 4.0%)				
Code Ref:	CBC 1133B.7.1.3 and ADA/ABA 403.3

As Built Meas:	11	Quantity:	LF	
Description:	Cross slope exceeds 2.0% (3.1% to 4.0%)			
As Built Desc:	3.0% cross slope			
Solution:	Demolish existing and construct new route			
Bar. Severity:	3 Hinderance	Cost Estimate:	\$1,375.00	Status:
Implementation Priority:	4	Facility Function:		
Implementation Phase:		Implementation Date:		
Official Responsible:

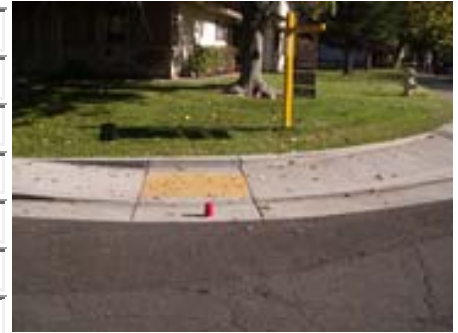
Field Date:	12/1/2010	Report Date:	12/1/2010	Barrier #:	2952
Location:	Bremen Dr and Cavan Dr - Corner B				
X Coordinate:	-121.31502				
Y Coordinate:	38.67955				
Barrier Area:	Curb Ramps				
Barrier Type:	12" Grooves - Existing (3.1% to 4.0%)				
Code Ref:	CBC 1127B.5.6

As Built Meas:	1	Quantity:	EACH	
Description:	12" grooves at top of curb ramp are not level (3.1% to 4.0%)			
As Built Desc:	3.8% at 12" grooves			
Solution:	Demolish existing and construct new curb ramp			
Bar. Severity:	3 Hindrance	Cost Estimate:	\$2,500.00	Status:
Implementation Priority:	4	Facility Function:		
Implementation Phase:		Implementation Date:		
Official Responsible:

Notes: Two - way intersection corners A,B. Corner A compliant

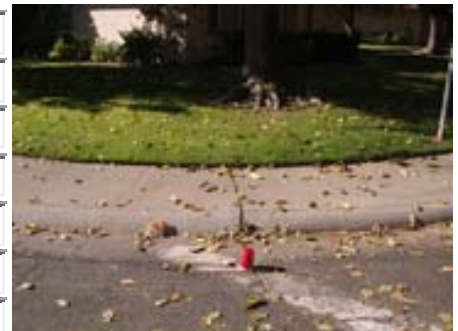
Field Date:	12/1/2010	Report Date:	12/1/2010	Barrier #:	2953
Location:	Bremen Dr and Longford Dr - Corner D				
X Coordinate:	-121.31439				
Y Coordinate:	38.67925				
Barrier Area:	Curb Ramps				
Barrier Type:	No Curb Ramp				
Code Ref:	CBC 1127B.5.1 and ADA/ABA 402.2

As Built Meas:	1	Quantity:	EACH	
Description:	No curb cut at corner (intersection)			
As Built Desc:	No curb ramp at corner			
Solution:	Demolish existing and construct curb cut			
Bar. Severity:	1 Necessary	Cost Estimate:	\$2,500.00	Status:
Implementation Priority:	4	Facility Function:		
Implementation Phase:		Implementation Date:		
Official Responsible:

Notes: Four - way intersection corners A,B,C,D. Corners A,B,C compliant

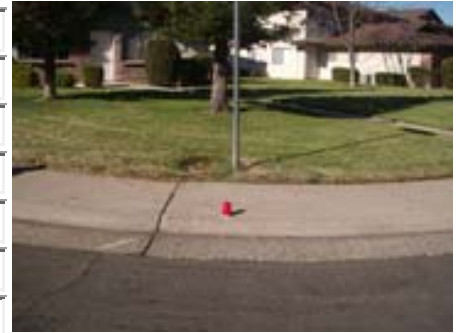
Field Date:	12/1/2010	Report Date:	12/1/2010	Barrier #:	2954
Location:	Carlow Dr and Bremen Dr - Corner A				
X Coordinate:	-121.31317				
Y Coordinate:	38.6791				
Barrier Area:	Curb Ramps				
Barrier Type:	No Curb Ramp				
Code Ref:	CBC 1127B.5.1 and ADA/ABA 402.2

As Built Meas:	1	Quantity:	EACH		
Description:	No curb cut at corner (intersection)				
As Built Desc:	No curb ramp at corner				
Solution:	Demolish existing and construct curb cut				
Bar. Severity:	1 Necessary	Cost Estimate:	\$2,500.00	Status:	
Implementation Priority:	4	Facility Function:			
Implementation Phase:		Implementation Date:			
Official Responsible:

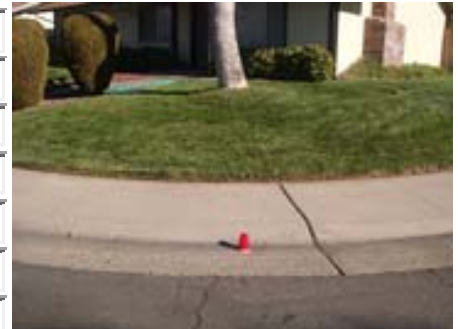
Field Date:	12/1/2010	Report Date:	12/1/2010	Barrier #:	2955
Location:	Carlow Dr and Bremen Dr - Corner B				
X Coordinate:	-121.31289				
Y Coordinate:	38.67909				
Barrier Area:	Curb Ramps				
Barrier Type:	No Curb Ramp				
Code Ref:	CBC 1127B.5.1 and ADA/ABA 402.2

As Built Meas:	1	Quantity:	EACH		
Description:	No curb cut at corner (intersection)				
As Built Desc:	No curb ramp at corner				
Solution:	Demolish existing and construct curb cut				
Bar. Severity:	1 Necessary	Cost Estimate:	\$2,500.00	Status:	
Implementation Priority:	4	Facility Function:			
Implementation Phase:		Implementation Date:			
Official Responsible:

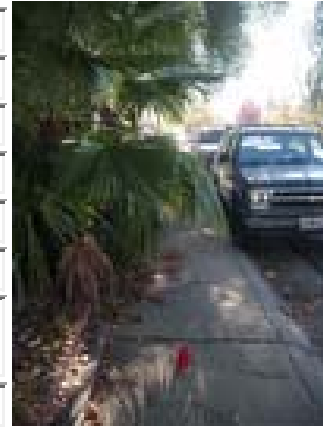
Field Date:	12/1/2010	Report Date:	12/1/2010	Barrier #:	2956
Location:	Carlow Dr - East				
X Coordinate:	-121.31289				
Y Coordinate:	38.67982				
Barrier Area:	Sidewalks				
Barrier Type:	Protruding Hazard				
Code Ref:	CBC 1133B.8.6.1 and ADA/ABA 307.2

As Built Meas:	1	Quantity:	JOB		
Description:	Protruding object in route of travel between 27" and 80" high				
As Built Desc:	32" high at tree branches				
Solution:	Remove object or provide detectable warning				
Bar. Severity:	1 Necessary	Cost Estimate:	\$1,400.00	Status:	
Implementation Priority:	4	Facility Function:			
Implementation Phase:		Implementation Date:			
Official Responsible:

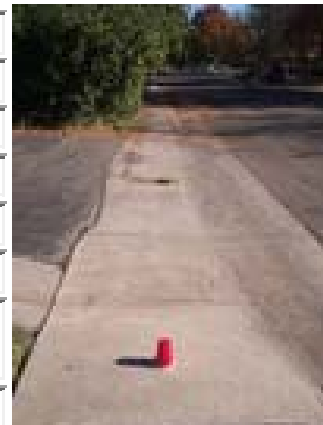
Field Date:	12/1/2010	Report Date:	12/1/2010	Barrier #:	2957
Location:	Bremen Dr - North				
X Coordinate:	-121.3125				
Y Coordinate:	38.67908				
Barrier Area:	Sidewalks				
Barrier Type:	Driveway - Existing (2.1% to 3.0%)				
Code Ref:	CBC 1133B.7.1.3 and ADA/ABA 403.3

As Built Meas:	32	Quantity:	LF		
Description:	Driveway cross slope exceeds 2.0% (2.1% to 3.0%)				
As Built Desc:	3.0% cross slope				
Solution:	Provide min. 48" wide level walkway through driveway				
Bar. Severity:	1 Necessary	Cost Estimate:	\$4,000.00	Status:	
Implementation Priority:	4	Facility Function:			
Implementation Phase:		Implementation Date:			
Official Responsible:

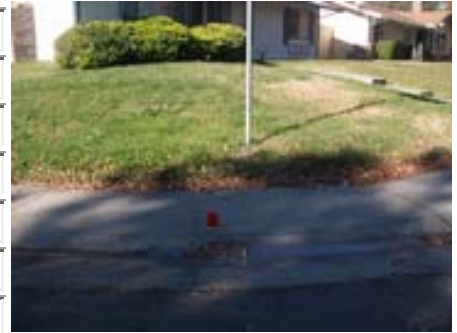
Field Date:	12/1/2010	Report Date:	12/1/2010	Barrier #:	2958
Location:	Bremen Dr and Louth Wy - Corner A				
X Coordinate:	-121.31208				
Y Coordinate:	38.67915				
Barrier Area:	Curb Ramps				
Barrier Type:	No Curb Ramp				
Code Ref:	CBC 1127B.5.1 and ADA/ABA 402.2

As Built Meas:	1	Quantity:	EACH		
Description:	No curb cut at corner (intersection)				
As Built Desc:	No curb ramp at corner				
Solution:	Demolish existing and construct curb cut				
Bar. Severity:	1 Necessary	Cost Estimate:	\$2,500.00	Status:	
Implementation Priority:	4	Facility Function:			
Implementation Phase:		Implementation Date:			
Official Responsible:

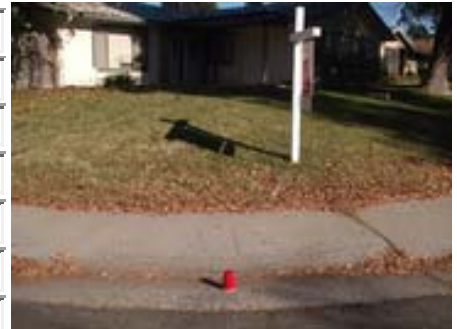
Field Date:	12/1/2010	Report Date:	12/1/2010	Barrier #:	2959
Location:	Bremen Dr and Louth Wy - Corner B				
X Coordinate:	-121.31183				
Y Coordinate:	38.6791				
Barrier Area:	Curb Ramps				
Barrier Type:	No Curb Ramp				
Code Ref:	CBC 1127B.5.1 and ADA/ABA 402.2

As Built Meas:	1	Quantity:	EACH		
Description:	No curb cut at corner (intersection)				
As Built Desc:	No curb ramp at corner				
Solution:	Demolish existing and construct curb cut				
Bar. Severity:	1 Necessary	Cost Estimate:	\$2,500.00	Status:	
Implementation Priority:	4	Facility Function:			
Implementation Phase:		Implementation Date:			
Official Responsible:

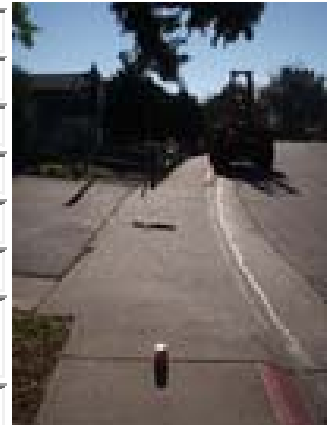
Field Date:	12/1/2010	Report Date:	12/1/2010	Barrier #:	2961
Location:	Louth Wy - East				
X Coordinate:	-121.31136				
Y Coordinate:	38.68117				
Barrier Area:	Sidewalks				
Barrier Type:	Driveway - Existing (3.1% to 4.0%)				
Code Ref:	CBC 1133B.7.1.3 and ADA/ABA 403.3

As Built Meas:	33	Quantity:	LF		
Description:	Driveway cross slope exceeds 2.0% (3.1% to 4.0%)				
As Built Desc:	3.3% cross slope				
Solution:	Provide min. 48" wide level walkway through driveway				
Bar. Severity:	2 Recommended	Cost Estimate:	\$4,125.00	Status:	
Implementation Priority:	4	Facility Function:			
Implementation Phase:		Implementation Date:			
Official Responsible:

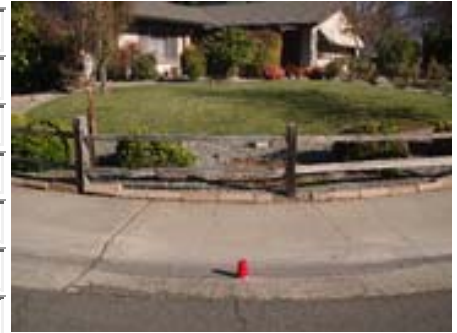
Field Date:	12/1/2010	Report Date:	12/1/2010	Barrier #:	2962
Location:	Louth Wy and Leirim Ct - Corner B				
X Coordinate:	-121.31146				
Y Coordinate:	38.68082				
Barrier Area:	Curb Ramps				
Barrier Type:	No Curb Ramp - Depressed Existing Curb				
Code Ref:	CBC 1127B.5.1 and ADA/ABA 402.2

As Built Meas:	1	Quantity:	EACH	
Description:	No compliant curb cut at corner (intersection)			
As Built Desc:	4.0% running slope at depressed area			
Solution:	Demolish existing and construct curb cut			
Bar. Severity:	1 Necessary	Cost Estimate:	\$2,500.00	Status:
Implementation Priority:	4	Facility Function:		
Implementation Phase:		Implementation Date:		
Official Responsible:

Notes: Two - way intersection corners B,C

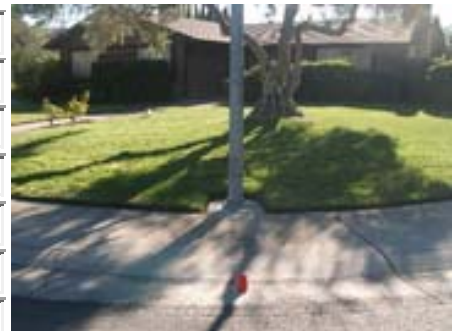
Field Date:	12/1/2010	Report Date:	12/1/2010	Barrier #:	2963
Location:	Louth Wy and Leirim Ct - Corner C				
X Coordinate:	-121.31156				
Y Coordinate:	38.68064				
Barrier Area:	Curb Ramps				
Barrier Type:	No Curb Ramp - Depressed Existing Curb				
Code Ref:	CBC 1127B.5.1 and ADA/ABA 402.2

As Built Meas:	1	Quantity:	EACH	
Description:	No compliant curb cut at corner (intersection)			
As Built Desc:	5.3% running slope at depressed area			
Solution:	Demolish existing and construct curb cut			
Bar. Severity:	1 Necessary	Cost Estimate:	\$2,500.00	Status:
Implementation Priority:	4	Facility Function:		
Implementation Phase:		Implementation Date:		
Official Responsible:

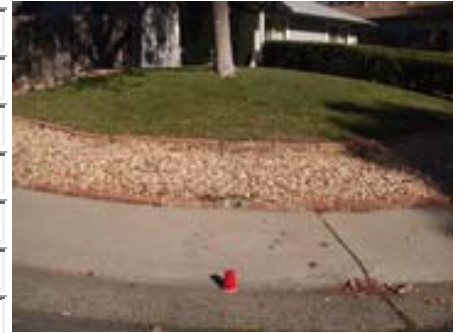
Field Date:	12/1/2010	Report Date:	12/1/2010	Barrier #:	2964
Location:	Louth Wy and Steffano Ct - Corner B				
X Coordinate:	-121.31192				
Y Coordinate:	38.67985				
Barrier Area:	Curb Ramps				
Barrier Type:	No Curb Ramp - Depressed Existing Curb				
Code Ref:	CBC 1127B.5.1 and ADA/ABA 402.2

As Built Meas:	1	Quantity:	EACH	
Description:	No compliant curb cut at corner (intersection)			
As Built Desc:	3.3% running slope at depressed area			
Solution:	Demolish existing and construct curb cut			
Bar. Severity:	1 Necessary	Cost Estimate:	\$2,500.00	Status:
Implementation Priority:	4	Facility Function:		
Implementation Phase:		Implementation Date:		
Official Responsible:

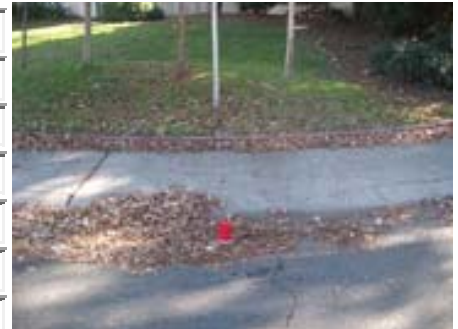
Field Date:	12/1/2010	Report Date:	12/1/2010	Barrier #:	2965
Location:	Louth Wy and Steffano Ct - Corner C				
X Coordinate:	-121.31193				
Y Coordinate:	38.67972				
Barrier Area:	Curb Ramps				
Barrier Type:	No Curb Ramp - Depressed Existing Curb				
Code Ref:	CBC 1127B.5.1 and ADA/ABA 402.2

As Built Meas:	1	Quantity:	EACH	
Description:	No compliant curb cut at corner (intersection)			
As Built Desc:	4.0% running slope at depressed area			
Solution:	Demolish existing and construct curb cut			
Bar. Severity:	1 Necessary	Cost Estimate:	\$2,500.00	Status:
Implementation Priority:	4	Facility Function:		
Implementation Phase:		Implementation Date:		
Official Responsible:

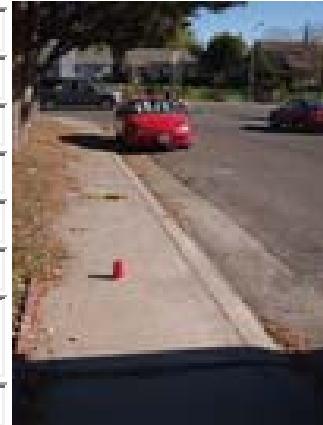
Field Date:	12/1/2010	Report Date:	12/1/2010	Barrier #:	2966A
Location:	Bremen Dr - South				
X Coordinate:	-121.31076				
Y Coordinate:	38.67907				
Barrier Area:	Sidewalks				
Barrier Type:	Cross Slope - Existing (2.1% to 3.0%)				
Code Ref:	CBC 1133B.7.1.3 and ADA/ABA 403.3

As Built Meas:	76	Quantity:	LF		
Description:	Cross slope exceeds 2.0% (2.1% to 3.0%)				
As Built Desc:	3.0% cross slope				
Solution:	Low severity barrier - no remediation recommended				
Bar. Severity:	4 Low Severity	Cost Estimate:	\$0.00	Status:	
Implementation Priority:	4	Facility Function:			
Implementation Phase:		Implementation Date:			
Official Responsible:

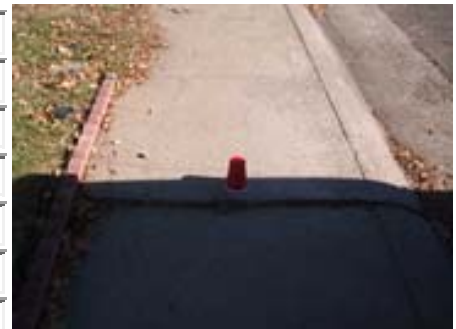
Field Date:	12/1/2010	Report Date:	12/1/2010	Barrier #:	2966B
Location:	Bremen Dr - South				
X Coordinate:	-121.31076				
Y Coordinate:	38.67907				
Barrier Area:	Sidewalks				
Barrier Type:	Abrupt Change in Level - > 1/2"				
Code Ref:	CBC 1133B.7.1 and ADA/ABA 303.3

As Built Meas:	4	Quantity:	LF		
Description:	Change in level greater than 1/2"				
As Built Desc:	1/2" lip in sidewalk surface				
Solution:	Grind or repair sidewalk to remove trip hazard				
Bar. Severity:	1 Necessary	Cost Estimate:	\$1,000.00	Status:	
Implementation Priority:	4	Facility Function:			
Implementation Phase:		Implementation Date:			
Official Responsible:

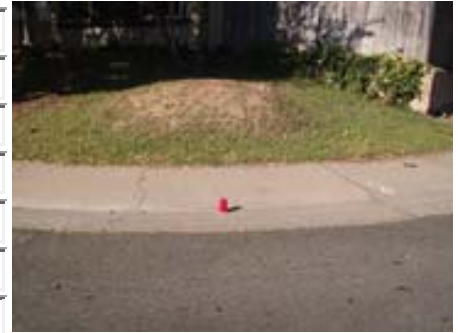
Field Date:	12/1/2010	Report Date:	12/1/2010	Barrier #:	2967
Location:	Bremen Dr and Van Maren Ln - Corner A				
X Coordinate:	-121.31052				
Y Coordinate:	38.67906				
Barrier Area:	Curb Ramps				
Barrier Type:	No Curb Ramp - Depressed Existing Curb				
Code Ref:	CBC 1127B.5.1 and ADA/ABA 402.2

As Built Meas:	1	Quantity:	EACH		
Description:	No compliant curb cut at corner (intersection)				
As Built Desc:	6.4% running slope at depressed area				
Solution:	Demolish existing and construct curb cut				
Bar. Severity:	1 Necessary	Cost Estimate:	\$2,500.00	Status:	
Implementation Priority:	4	Facility Function:			
Implementation Phase:		Implementation Date:			
Official Responsible:

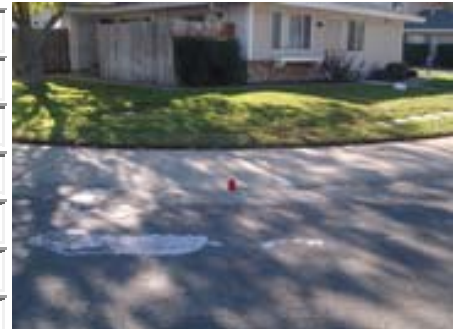
Field Date:	12/1/2010	Report Date:	12/1/2010	Barrier #:	2968
Location:	Bremen Dr and Van Maren Ln - Corner D				
X Coordinate:	-121.31053				
Y Coordinate:	38.67891				
Barrier Area:	Curb Ramps				
Barrier Type:	No Curb Ramp - Depressed Existing Curb				
Code Ref:	CBC 1127B.5.1 and ADA/ABA 402.2

As Built Meas:	1	Quantity:	EACH		
Description:	No compliant curb cut at corner (intersection)				
As Built Desc:	5.0% running slope at depressed area				
Solution:	Demolish existing and construct curb cut				
Bar. Severity:	1 Necessary	Cost Estimate:	\$2,500.00	Status:	
Implementation Priority:	4	Facility Function:			
Implementation Phase:		Implementation Date:			
Official Responsible:

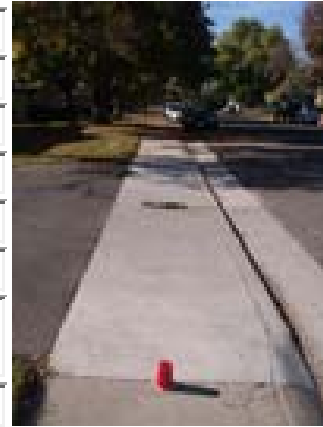
Field Date:	12/1/2010	Report Date:	12/1/2010	Barrier #:	2969
Location:	Bremen Dr - South				
X Coordinate:	-121.31089				
Y Coordinate:	38.67897				
Barrier Area:	Sidewalks				
Barrier Type:	Driveway - Existing (2.1% to 3.0%)				
Code Ref:	CBC 1133B.7.1.3 and ADA/ABA 403.3

As Built Meas:	37	Quantity:	LF	
Description:	Driveway cross slope exceeds 2.0% (2.1% to 3.0%)			
As Built Desc:	2.8% cross slope			
Solution:	Provide min. 48" wide level walkway through driveway			
Bar. Severity:	1 Necessary	Cost Estimate:	\$4,625.00	Status:
Implementation Priority:	4	Facility Function:		
Implementation Phase:		Implementation Date:		
Official Responsible:

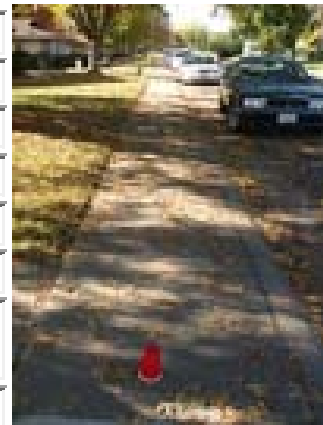
Field Date:	12/1/2010	Report Date:	12/1/2010	Barrier #:	2970
Location:	Bremen Dr - South				
X Coordinate:	-121.31112				
Y Coordinate:	38.67895				
Barrier Area:	Sidewalks				
Barrier Type:	Cross Slope - Existing (3.1% to 4.0%)				
Code Ref:	CBC 1133B.7.1.3 and ADA/ABA 403.3

As Built Meas:	50	Quantity:	LF	
Description:	Cross slope exceeds 2.0% (3.1% to 4.0%)			
As Built Desc:	3.6% cross slope			
Solution:	Demolish existing and construct new route			
Bar. Severity:	3 Hinderance	Cost Estimate:	\$6,250.00	Status:
Implementation Priority:	4	Facility Function:		
Implementation Phase:		Implementation Date:		
Official Responsible:

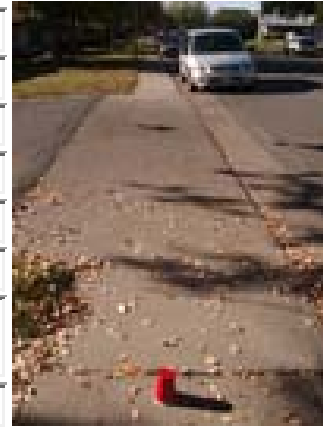
Field Date:	12/1/2010	Report Date:	12/1/2010	Barrier #:	2971
Location:	Bremen Dr - South				
X Coordinate:	-121.31133				
Y Coordinate:	38.67896				
Barrier Area:	Sidewalks				
Barrier Type:	Driveway - Existing (4.1% to 4.9%)				
Code Ref:	CBC 1133B.7.1.3 and ADA/ABA 403.3

As Built Meas:	37	Quantity:	LF	
Description:	Driveway cross slope exceeds 2.0% (4.1% to 4.9%)			
As Built Desc:	4.4% cross slope			
Solution:	Provide min. 48" wide level walkway through driveway			
Bar. Severity:	3 Hinderance	Cost Estimate:	\$4,625.00	Status:
Implementation Priority:	4	Facility Function:		
Implementation Phase:		Implementation Date:		
Official Responsible:

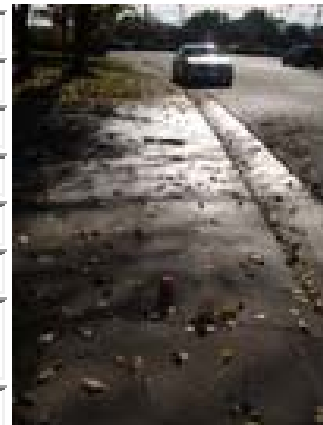
Field Date:	12/1/2010	Report Date:	12/1/2010	Barrier #:	2972
Location:	Longford Dr - East				
X Coordinate:	-121.31441				
Y Coordinate:	38.67852				
Barrier Area:	Sidewalks				
Barrier Type:	Driveway - Existing (2.1% to 3.0%)				
Code Ref:	CBC 1133B.7.1.3 and ADA/ABA 403.3

As Built Meas:	35	Quantity:	LF	
Description:	Driveway cross slope exceeds 2.0% (2.1% to 3.0%)			
As Built Desc:	2.5% cross slope			
Solution:	Provide min. 48" wide level walkway through driveway			
Bar. Severity:	1 Necessary	Cost Estimate:	\$4,375.00	Status:
Implementation Priority:	4	Facility Function:		
Implementation Phase:		Implementation Date:		
Official Responsible:

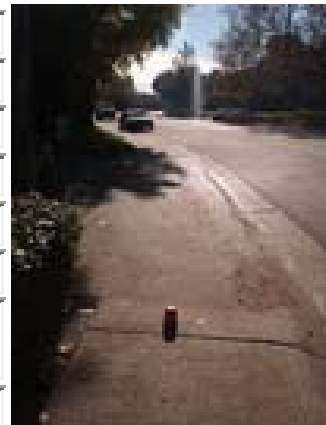
Field Date:	12/1/2010	Report Date:	12/1/2010	Barrier #:	2974
Location:	Bremen Dr - East				
X Coordinate:	-121.31636				
Y Coordinate:	38.67909				
Barrier Area:	Sidewalks				
Barrier Type:	Driveway - Existing (5.0% or more)				
Code Ref:	CBC 1133B.7.1.3 and ADA/ABA 403.3

As Built Meas:	37	Quantity:	LF
Description:	Driveway cross slope exceeds 2.0% (5.0% or more)		
As Built Desc:	5.1% cross slope		
Solution:	Provide min. 48" wide level walkway through driveway		
Bar. Severity:	4 Low Severity	Cost Estimate:	\$4,625.00
Implementation Priority:	4	Facility Function:	
Implementation Phase:		Implementation Date:	
Official Responsible:

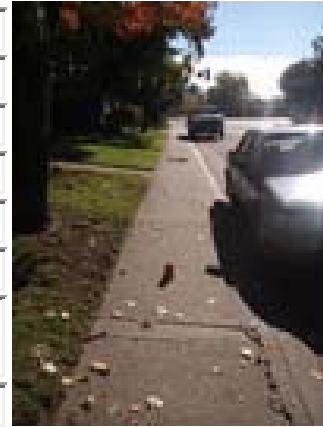
Field Date:	12/1/2010	Report Date:	12/1/2010	Barrier #:	2975
Location:	Bremen Dr - East				
X Coordinate:	-121.31638				
Y Coordinate:	38.67883				
Barrier Area:	Sidewalks				
Barrier Type:	Cross Slope - Existing (4.1% to 4.9%)				
Code Ref:	CBC 1133B.7.1.3 and ADA/ABA 403.3

As Built Meas:	30	Quantity:	LF		
Description:	Cross slope exceeds 2.0% (4.1% to 4.9%)				
As Built Desc:	4.4% cross slope				
Solution:	Demolish existing and construct new route				
Bar. Severity:	2 Recommended	Cost Estimate:	\$3,750.00	Status:	
Implementation Priority:	4	Facility Function:			
Implementation Phase:		Implementation Date:			
Official Responsible:

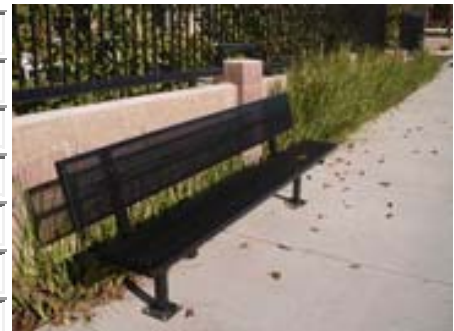
Field Date:	12/1/2010	Report Date:	12/1/2010	Barrier #:	2976A
Location:	Greenback Ln - North				
X Coordinate:	-121.31493				
Y Coordinate:	38.67827				
Barrier Area:	Bus Stops and Shelters				
Barrier Type:	Bench Seat Depth				
Code Ref:	ADAAG 4.37.1 and ADA/ABA 903.4

As Built Meas:	1	Quantity:	EACH		
Description:	Bench seat depth not 20" - 24" deep				
As Built Desc:	16" bench seat depth				
Solution:	Provide min. 1 accessible bench at bench stop				
Bar. Severity:	3 Hindrance	Cost Estimate:	\$775.00	Status:	
Implementation Priority:	1	Facility Function:			
Implementation Phase:		Implementation Date:			
Official Responsible:

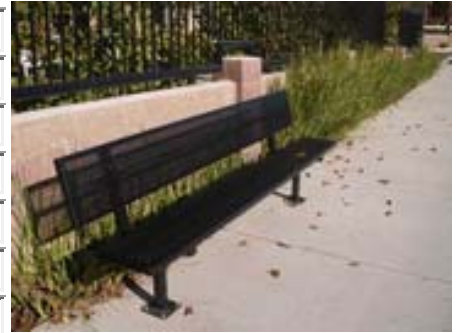
Field Date:	12/1/2010	Report Date:	12/1/2010	Barrier #:	2976B
Location:	Greenback Ln - North				
X Coordinate:	-121.31493				
Y Coordinate:	38.67827				
Barrier Area:	Bus Stops and Shelters				
Barrier Type:	Bench Seat Height				
Code Ref:	ADAAG 4.37.3* and ADA/ABA 903.4

As Built Meas:	1	Quantity:	EACH
Description:	Bench seat height not between 17" - 19"		
As Built Desc:	12-1/2" bench seat height		
Solution:	Provide new compliant bench or remount at compliant height where possible		
Bar. Severity:	3 Hindrance	Cost Estimate:	\$0.00
Implementation Priority:	1	Facility Function:	
Implementation Phase:		Implementation Date:	
Official Responsible:

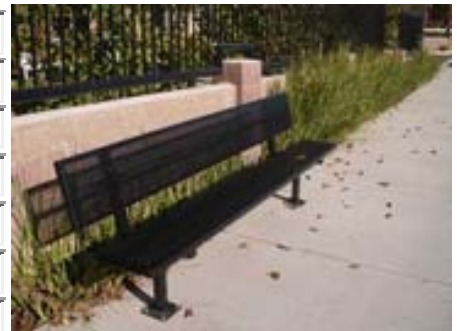
Field Date:	12/1/2010	Report Date:	12/1/2010	Barrier #:	2976C
Location:	Greenback Ln - North				
X Coordinate:	-121.31493				
Y Coordinate:	38.67827				
Barrier Area:	Bus Stops and Shelters				
Barrier Type:	Bench Back Support				
Code Ref:	ADAAG 4.37.4 and ADA/ABA 903.4

As Built Meas:	1	Quantity:	EACH
Description:	Bench has no back support of at least 18" high		
As Built Desc:	12-1/2" back support height		
Solution:	Provide min. 1 accessible bench at bench stop or shelter		
Bar. Severity:	3 Hindrance	Cost Estimate:	\$0.00
Implementation Priority:	1	Facility Function:	
Implementation Phase:		Implementation Date:	
Official Responsible:

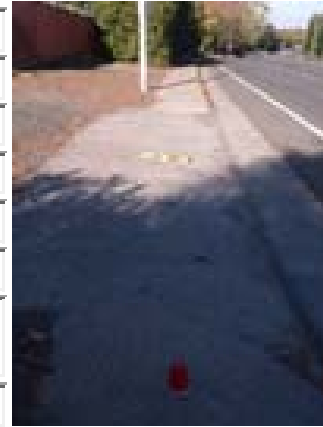
Field Date:	12/1/2010	Report Date:	12/1/2010	Barrier #:	2977
Location:	Van Maren Ln - West				
X Coordinate:	-121.31065				
Y Coordinate:	38.68043				
Barrier Area:	Sidewalks				
Barrier Type:	Driveway - Existing (5.0% or more)				
Code Ref:	CBC 1133B.7.1.3 and ADA/ABA 403.3

As Built Meas:	29	Quantity:	LF		
Description:	Driveway cross slope exceeds 2.0% (5.0% or more)				
As Built Desc:	6.4% cross slope				
Solution:	Provide min. 48" wide level walkway through driveway				
Bar. Severity:	4 Low Severity	Cost Estimate:	\$3,625.00	Status:	
Implementation Priority:	1	Facility Function:			
Implementation Phase:		Implementation Date:			
Official Responsible:

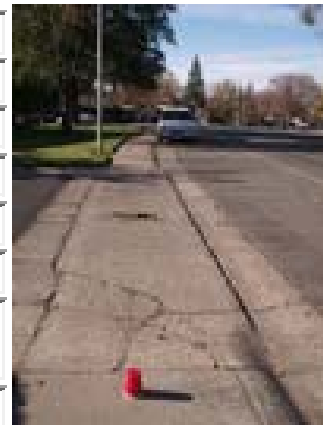
Field Date:	12/1/2010	Report Date:	12/1/2010	Barrier #:	2978
Location:	Donegal Dr - South				
X Coordinate:	-121.31298				
Y Coordinate:	38.68152				
Barrier Area:	Sidewalks				
Barrier Type:	Driveway - Existing (3.1% to 4.0%)				
Code Ref:	CBC 1133B.7.1.3 and ADA/ABA 403.3

As Built Meas:	37	Quantity:	LF		
Description:	Driveway cross slope exceeds 2.0% (3.1% to 4.0%)				
As Built Desc:	3.1% cross slope				
Solution:	Provide min. 48" wide level walkway through driveway				
Bar. Severity:	2 Recommended	Cost Estimate:	\$4,625.00	Status:	
Implementation Priority:	3	Facility Function:			
Implementation Phase:		Implementation Date:			
Official Responsible:

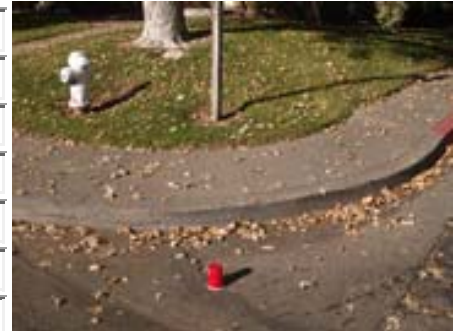
Field Date:	12/1/2010	Report Date:	12/1/2010	Barrier #:	2981
Location:	Donegal Dr and Wexford Cir - Corner A				
X Coordinate:	-121.31277				
Y Coordinate:	38.68159				
Barrier Area:	Curb Ramps				
Barrier Type:	No Curb Ramp				
Code Ref:	CBC 1127B.5.1 and ADA/ABA 402.2

As Built Meas:	1	Quantity:	EACH	
Description:	No curb cut at corner (intersection)			
As Built Desc:	No curb ramp at corner			
Solution:	Demolish existing and construct curb cut			
Bar. Severity:	1 Necessary	Cost Estimate:	\$2,500.00	Status:
Implementation Priority:	3	Facility Function:		
Implementation Phase:		Implementation Date:		
Official Responsible:

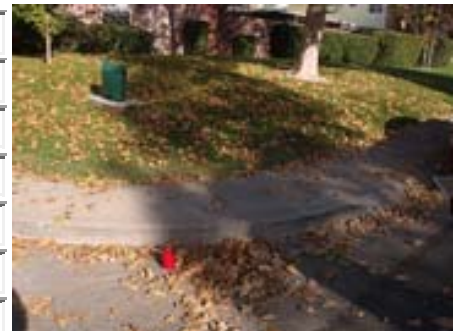
Field Date:	12/1/2010	Report Date:	12/1/2010	Barrier #:	2982
Location:	Donegal Dr and Wexford Cir - Corner B				
X Coordinate:	-121.3127				
Y Coordinate:	38.68158				
Barrier Area:	Curb Ramps				
Barrier Type:	No Curb Ramp				
Code Ref:	CBC 1127B.5.1 and ADA/ABA 402.2

As Built Meas:	1	Quantity:	EACH	
Description:	No curb cut at corner (intersection)			
As Built Desc:	No curb ramp at corner			
Solution:	Demolish existing and construct curb cut			
Bar. Severity:	1 Necessary	Cost Estimate:	\$2,500.00	Status:
Implementation Priority:	3	Facility Function:		
Implementation Phase:		Implementation Date:		
Official Responsible:

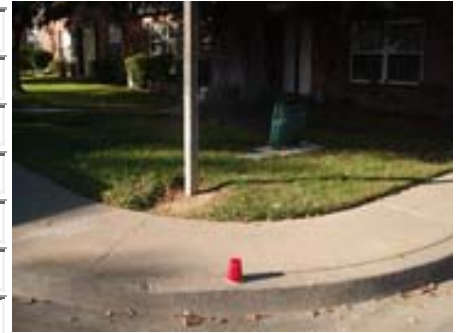
Field Date:	12/1/2010	Report Date:	12/1/2010	Barrier #:	2983
Location:	Donegal Dr and Wexford Cir - Corner A				
X Coordinate:	-121.31113				
Y Coordinate:	38.68159				
Barrier Area:	Curb Ramps				
Barrier Type:	No Curb Ramp				
Code Ref:	CBC 1127B.5.1 and ADA/ABA 402.2

As Built Meas:	1	Quantity:	EACH		
Description:	No curb cut at corner (intersection)				
As Built Desc:	No curb ramp at corner				
Solution:	Demolish existing and construct curb cut				
Bar. Severity:	1 Necessary	Cost Estimate:	\$2,500.00	Status:	
Implementation Priority:	3	Facility Function:			
Implementation Phase:		Implementation Date:			
Official Responsible:

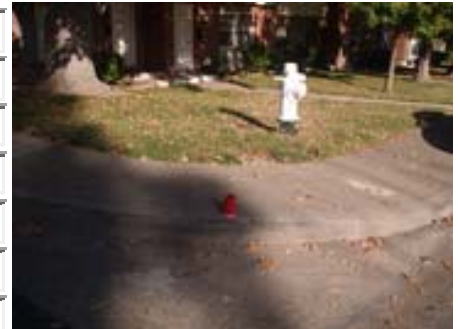
Field Date:	12/1/2010	Report Date:	12/1/2010	Barrier #:	2984
Location:	Donegal Dr and Wexford Cir - Corner B				
X Coordinate:	-121.31104				
Y Coordinate:	38.68158				
Barrier Area:	Curb Ramps				
Barrier Type:	No Curb Ramp				
Code Ref:	CBC 1127B.5.1 and ADA/ABA 402.2

As Built Meas:	1	Quantity:	EACH		
Description:	No curb cut at corner (intersection)				
As Built Desc:	No curb ramp at corner				
Solution:	Demolish existing and construct curb cut				
Bar. Severity:	1 Necessary	Cost Estimate:	\$2,500.00	Status:	
Implementation Priority:	3	Facility Function:			
Implementation Phase:		Implementation Date:			
Official Responsible:

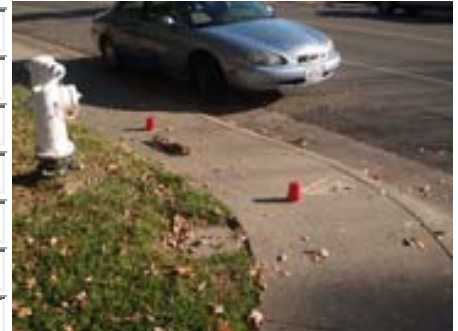
Field Date:	12/1/2010	Report Date:	12/1/2010	Barrier #:	2985
Location:	Donegal Dr - North				
X Coordinate:	-121.31099				
Y Coordinate:	38.68158				
Barrier Area:	Sidewalks				
Barrier Type:	Running Slope (New Construction)				
Code Ref:	CBC 1133B.7.3 and ADA/ABA 403.3

As Built Meas:	8	Quantity:	LF
Description:	Running slope exceeds 5.0% where roadway slope does not		
As Built Desc:	7.1% running slope		
Solution:	Demolish existing and construct new route		
Bar. Severity:	1 Necessary	Cost Estimate:	\$1,000.00
Implementation Priority:	3	Facility Function:	
Implementation Phase:		Implementation Date:	
Official Responsible:

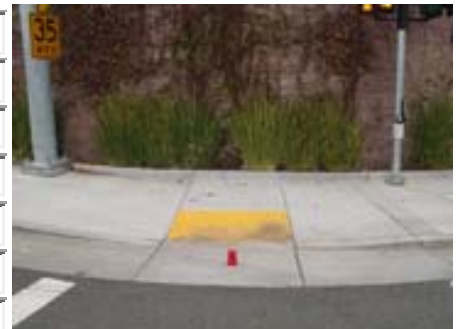
Field Date:	12/2/2010	Report Date:	12/2/2010	Barrier #:	2986A
Location:	Greenback Ln and Bremen Dr - Corner A A-A				
X Coordinate:	-121.31669				
Y Coordinate:	38.67825				
Barrier Area:	Curb Ramps				
Barrier Type:	12" Grooves - Existing (4.1% to 4.9%)				
Code Ref:	CBC 1127B.5.6

As Built Meas:	1	Quantity:	EACH
Description:	12" grooves at top of curb ramp are not level (4.1% to 4.9%)		
As Built Desc:	4.6% at 12" grooves		
Solution:	Demolish existing and construct new curb ramp		
Bar. Severity:	2 Recommended	Cost Estimate:	\$2,500.00
Implementation Priority:	1	Facility Function:	
Implementation Phase:		Implementation Date:	
Official Responsible:

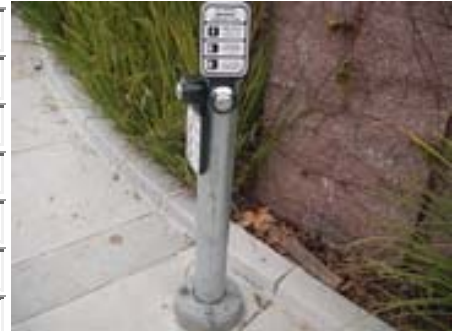
Field Date:	12/2/2010	Report Date:	12/2/2010	Barrier #:	2986B
Location:	Greenback Ln and Bremen Dr - Corner A A-A				
X Coordinate:	-121.31669				
Y Coordinate:	38.67825				
Barrier Area:	Signalized Intersections				
Barrier Type:	APS Vibrotactile Control				
Code Ref:	PROWAG R306.2

As Built Meas:	1	Quantity:	JOB		
Description:	No vibrotactile pedestrian buttons provided				
As Built Desc:	No vibrotactile buttons provided				
Solution:	Recommended: Provide vibrotactile ped buttons				
Bar. Severity:	1 Necessary	Cost Estimate:	\$0.00	Status:	
Implementation Priority:	1	Facility Function:			
Implementation Phase:		Implementation Date:			
Official Responsible:

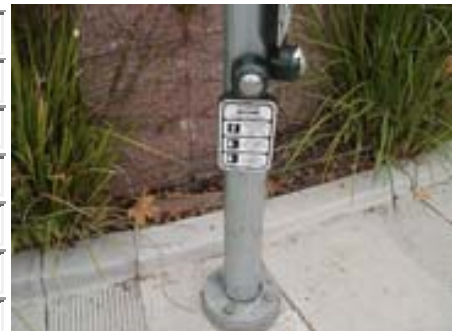
Field Date:	12/2/2010	Report Date:	12/2/2010	Barrier #:	2986C
Location:	Greenback Ln and Bremen Dr - Corner A A-B				
X Coordinate:	-121.31669				
Y Coordinate:	38.67825				
Barrier Area:	Signalized Intersections				
Barrier Type:	APS Vibrotactile Control				
Code Ref:	PROWAG R306.2

As Built Meas:	1	Quantity:	JOB		
Description:	No vibrotactile pedestrian buttons provided				
As Built Desc:	No vibrotactile buttons provided				
Solution:	Recommended: Provide vibrotactile ped buttons				
Bar. Severity:	1 Necessary	Cost Estimate:	\$4,700.00	Status:	
Implementation Priority:	1	Facility Function:			
Implementation Phase:		Implementation Date:			
Official Responsible:

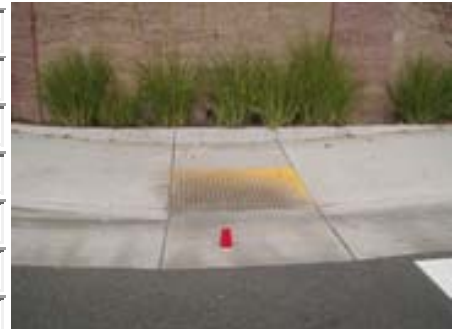
Field Date:	12/2/2010	Report Date:	12/2/2010	Barrier #:	2987B
Location:	Greenback Ln and Bremen Dr - Corner B A-A				
X Coordinate:	-121.31641				
Y Coordinate:	38.67826				
Barrier Area:	Curb Ramps				
Barrier Type:	12" Grooves - Existing (>5.0%)				
Code Ref:	CBC 1127B.5.6

As Built Meas:	1	Quantity:	EACH		
Description:	12" grooves at top of curb ramp are not level (>5.0%)				
As Built Desc:	5.4% at 12" grooves				
Solution:	Demolish existing and construct new curb ramp				
Bar. Severity:	1 Necessary	Cost Estimate:	\$0.00	Status:	
Implementation Priority:	1	Facility Function:			
Implementation Phase:		Implementation Date:			
Official Responsible:
