**DRAFT ADA TRANSITION PLAN UPDATE  
NEIGHBORHOOD AREA 4 ARCADE CREEK  
SEPTEMBER 20, 2011**

CITY OF CITRUS HEIGHTS

## Arcade Creek Neighborhood Area

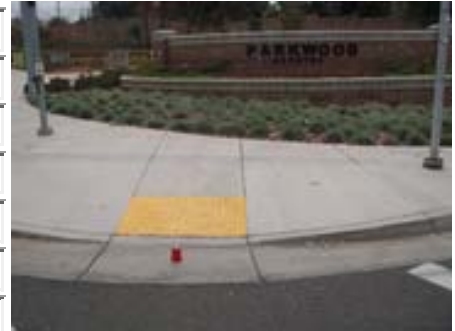
Field Date:	12/2/2010	Report Date:	12/2/2010	Barrier #:	2988A
Location:	Greenback Ln and Bremen Dr - Corner C A-B				
X Coordinate:	-121.31637				
Y Coordinate:	38.67795				
Barrier Area:	Curb Ramps				
Barrier Type:	12" Grooves - Existing (4.1% to 4.9%)				
Code Ref:	CBC 1127B.5.6

As Built Meas:	1	Quantity:	EACH	
Description:	12" grooves at top of curb ramp are not level (4.1% to 4.9%)			
As Built Desc:	4.1% at 12" grooves			
Solution:	Demolish existing and construct new curb ramp			
Bar. Severity:	2 Recommended	Cost Estimate:	\$2,500.00	Status:
Implementation Priority:	1	Facility Function:		
Implementation Phase:		Implementation Date:		
Official Responsible:

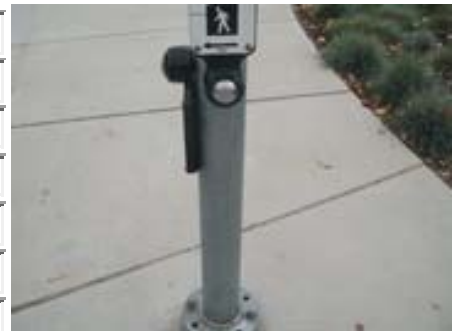
Field Date:	12/2/2010	Report Date:	12/2/2010	Barrier #:	2988B
Location:	Greenback Ln and Bremen Dr - Corner C A-B				
X Coordinate:	-121.31637				
Y Coordinate:	38.67795				
Barrier Area:	Signalized Intersections				
Barrier Type:	APS Vibrotactile Control				
Code Ref:	PROWAG R306.2

As Built Meas:	1	Quantity:	JOB	
Description:	No vibrotactile pedestrian buttons provided			
As Built Desc:	No vibrotactile buttons provided			
Solution:	Recommended: Provide vibrotactile ped buttons			
Bar. Severity:	1 Necessary	Cost Estimate:	\$4,700.00	Status:
Implementation Priority:	1	Facility Function:		
Implementation Phase:		Implementation Date:		
Official Responsible:

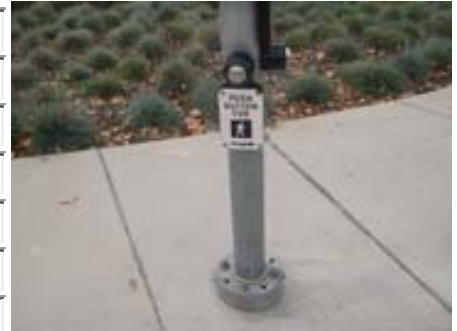
Field Date:	12/2/2010	Report Date:	12/2/2010	Barrier #:	2988C
Location:	Greenback Ln and Bremen Dr - Corner C A-A				
X Coordinate:	-121.31637				
Y Coordinate:	38.67795				
Barrier Area:	Signalized Intersections				
Barrier Type:	APS Vibrotactile Control				
Code Ref:	PROWAG R306.2

As Built Meas:	1	Quantity:	JOB		
Description:	No vibrotactile pedestrian buttons provided				
As Built Desc:	No vibrotactile buttons provided				
Solution:	Recommended: Provide vibrotactile ped buttons				
Bar. Severity:	1 Necessary	Cost Estimate:	\$4,700.00	Status:	
Implementation Priority:	1	Facility Function:			
Implementation Phase:		Implementation Date:			
Official Responsible:

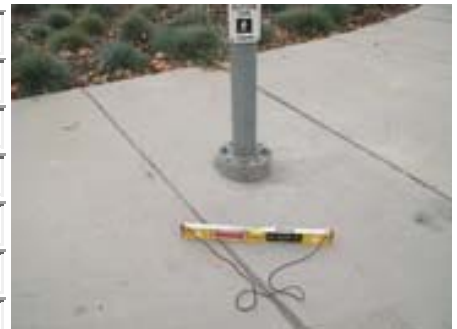
Field Date:	12/2/2010	Report Date:	12/2/2010	Barrier #:	2988D
Location:	Greenback Ln and Bremen Dr - Corner C A-A				
X Coordinate:	-121.31637				
Y Coordinate:	38.67795				
Barrier Area:	Signalized Intersections				
Barrier Type:	Ped Button - Existing Landing (3.1% to 4.0%)				
Code Ref:	CBC 1118B.4

As Built Meas:	1	Quantity:	JOB		
Description:	Landing at pedestrian button not level (3.1% to 4.0%)				
As Built Desc:	3.5% landing slope				
Solution:	Relocated pedestrian button to level area				
Bar. Severity:	3 Hinderance	Cost Estimate:	\$1,200.00	Status:	
Implementation Priority:	1	Facility Function:			
Implementation Phase:		Implementation Date:			
Official Responsible:

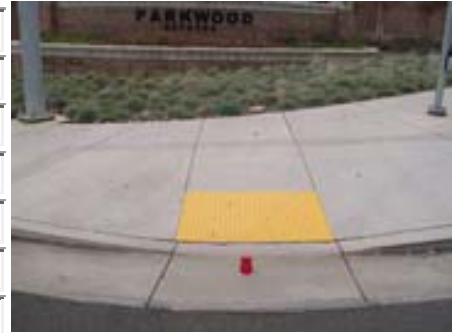
Field Date:	12/2/2010	Report Date:	12/2/2010	Barrier #:	2989A
Location:	Greenback Ln and Bremen Dr - Corner D A-B				
X Coordinate:	-121.31664				
Y Coordinate:	38.67794				
Barrier Area:	Curb Ramps				
Barrier Type:	12" Grooves - Existing (>5.0%)				
Code Ref:	CBC 1127B.5.6

As Built Meas:	1	Quantity:	EACH
Description:	12" grooves at top of curb ramp are not level (>5.0%)		
As Built Desc:	7.6% at 12" grooves		
Solution:	Demolish existing and construct new curb ramp		
Bar. Severity:	1 Necessary	Cost Estimate:	\$2,500.00
Implementation Priority:	1	Facility Function:	
Implementation Phase:		Implementation Date:	
Official Responsible:

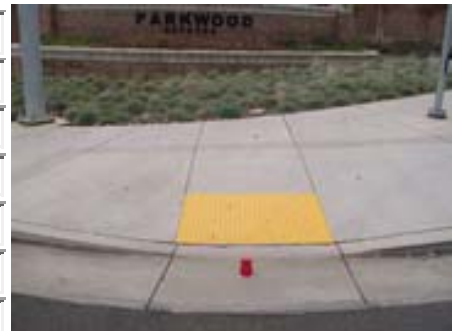
Field Date:	12/2/2010	Report Date:	12/2/2010	Barrier #:	2989B
Location:	Greenback Ln and Bremen Dr - Corner D A-B				
X Coordinate:	-121.31664				
Y Coordinate:	38.67794				
Barrier Area:	Curb Ramps				
Barrier Type:	Cross Slope - Existing (4.1% to 4.9%)				
Code Ref:	CBC 1127B.5.3 and ADA/ABA 406.2

As Built Meas:	1	Quantity:	EACH
Description:	Ramp run cross slope exceeds 2.0% (4.1% to 4.9%)		
As Built Desc:	4.6% cross slope		
Solution:	Demolish existing and construct new curb ramp		
Bar. Severity:	2 Recommended	Cost Estimate:	\$0.00
Implementation Priority:	1	Facility Function:	
Implementation Phase:		Implementation Date:	
Official Responsible:

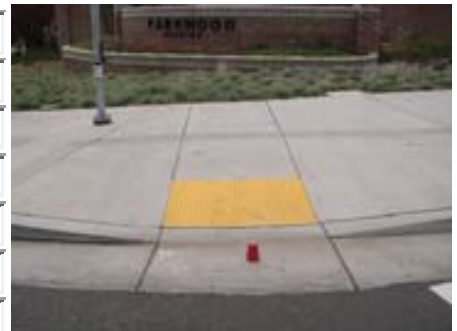
Field Date:	12/2/2010	Report Date:	12/2/2010	Barrier #:	2989D
Location:	Greenback Ln and Bremen Dr - Corner D A-A				
X Coordinate:	-121.31664				
Y Coordinate:	38.67794				
Barrier Area:	Curb Ramps				
Barrier Type:	Cross Slope - Existing (2.1% to 3.0%)				
Code Ref:	CBC 1127B.5.3 and ADA/ABA 406.2

As Built Meas:	1	Quantity:	EACH
Description:	Ramp run cross slope exceeds 2.0% (2.1% to 3.0%)		
As Built Desc:	2.8% cross slope		
Solution:	Demolish existing and construct new curb ramp		
Bar. Severity:	4 Low Severity	Cost Estimate:	\$0.00
Implementation Priority:	1	Facility Function:	
Implementation Phase:		Implementation Date:	
Official Responsible:

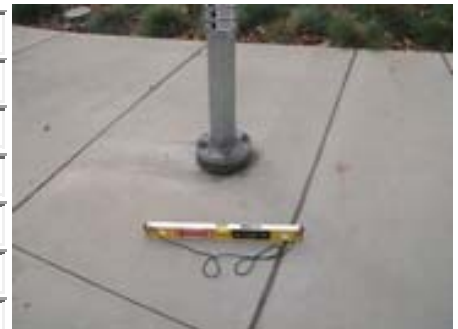
Field Date:	12/2/2010	Report Date:	12/2/2010	Barrier #:	2989F
Location:	Greenback Ln and Bremen Dr - Corner D A-B				
X Coordinate:	-121.31664				
Y Coordinate:	38.67794				
Barrier Area:	Signalized Intersections				
Barrier Type:	Ped Button - Existing Landing (4.1% to 4.9%)				
Code Ref:	CBC 1118B.4

As Built Meas:	1	Quantity:	JOB		
Description:	Landing at pedestrian button not level (4.1% to 4.9%)				
As Built Desc:	4.2% landing slope				
Solution:	Relocated pedestrian button to level area				
Bar. Severity:	2 Recommended	Cost Estimate:	\$1,200.00	Status:	
Implementation Priority:	1	Facility Function:			
Implementation Phase:		Implementation Date:			
Official Responsible:

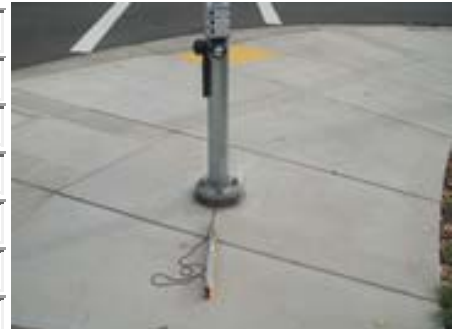
Field Date:	12/2/2010	Report Date:	12/2/2010	Barrier #:	2989H
Location:	Greenback Ln and Bremen Dr - Corner D A-A				
X Coordinate:	-121.31664				
Y Coordinate:	38.67794				
Barrier Area:	Signalized Intersections				
Barrier Type:	Ped Button - Existing Landing(5.0% or more)				
Code Ref:	CBC 1118B.4

As Built Meas:	1	Quantity:	JOB		
Description:	Landing at pedestrian button not level (5.0% or more)				
As Built Desc:	6.2% landing slope				
Solution:	Relocated pedestrian button to level area				
Bar. Severity:	1 Necessary	Cost Estimate:	\$1,200.00	Status:	
Implementation Priority:	1	Facility Function:			
Implementation Phase:		Implementation Date:			
Official Responsible:

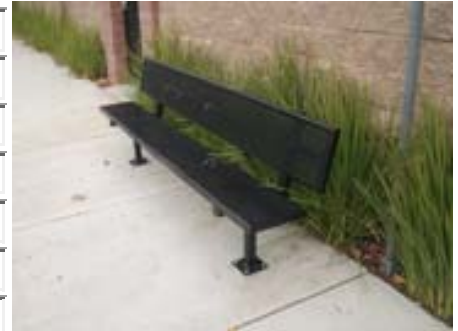
Field Date:	12/2/2010	Report Date:	12/2/2010	Barrier #:	2990A
Location:	Greenback Ln - North				
X Coordinate:	-121.31688				
Y Coordinate:	38.67828				
Barrier Area:	Bus Stops and Shelters				
Barrier Type:	Bench Seat Depth				
Code Ref:	ADAAG 4.37.1 and ADA/ABA 903.4

As Built Meas:	1	Quantity:	EACH		
Description:	Bench seat depth not 20" - 24" deep				
As Built Desc:	12-1/2" bench seat depth				
Solution:	Provide min. 1 accessible bench at bench stop				
Bar. Severity:	3 Hindrance	Cost Estimate:	\$775.00	Status:	
Implementation Priority:	1	Facility Function:			
Implementation Phase:		Implementation Date:			
Official Responsible:

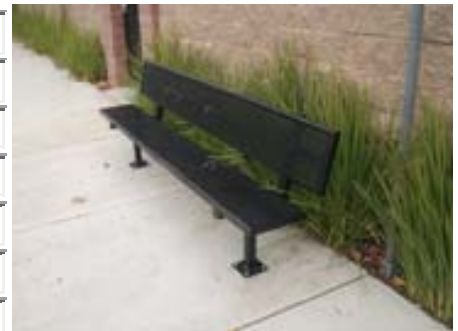
Field Date:	12/2/2010	Report Date:	12/2/2010	Barrier #:	2990B
Location:	Greenback Ln - North				
X Coordinate:	-121.31688				
Y Coordinate:	38.67828				
Barrier Area:	Bus Stops and Shelters				
Barrier Type:	Bench Back Support				
Code Ref:	ADAAG 4.37.4 and ADA/ABA 903.4

As Built Meas:	1	Quantity:	EACH		
Description:	Bench has no back support of at least 18" high				
As Built Desc:	16" back support height				
Solution:	Provide min. 1 accessible bench at bench stop or shelter				
Bar. Severity:	3 Hindrance	Cost Estimate:	\$0.00	Status:	
Implementation Priority:	1	Facility Function:			
Implementation Phase:		Implementation Date:			
Official Responsible:

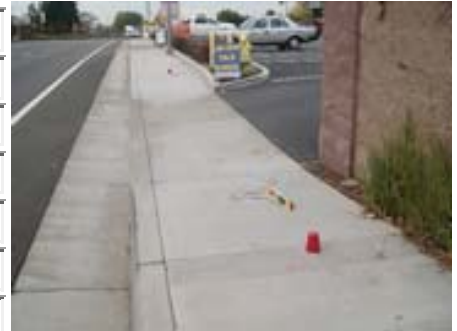
Field Date:	12/2/2010	Report Date:	12/2/2010	Barrier #:	2991
Location:	Greenback Ln - North				
X Coordinate:	-121.31808				
Y Coordinate:	38.67826				
Barrier Area:	Sidewalks				
Barrier Type:	Driveway - Existing (5.0% or more)				
Code Ref:	CBC 1133B.7.1.3 and ADA/ABA 403.3

As Built Meas:	38	Quantity:	LF		
Description:	Driveway cross slope exceeds 2.0% (5.0% or more)				
As Built Desc:	9.3% running slope				
Solution:	Provide min. 48" wide level walkway through driveway				
Bar. Severity:	4 Low Severity	Cost Estimate:	\$4,750.00	Status:	
Implementation Priority:	1	Facility Function:			
Implementation Phase:		Implementation Date:			
Official Responsible:

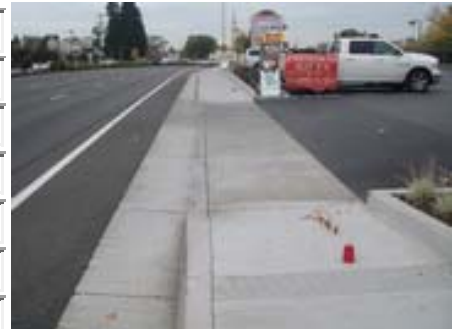
Field Date:	12/2/2010	Report Date:	12/2/2010	Barrier #:	2992
Location:	Greenback Ln - North				
X Coordinate:	-121.31827				
Y Coordinate:	38.67827				
Barrier Area:	Sidewalks				
Barrier Type:	Driveway - Existing (5.0% or more)				
Code Ref:	CBC 1133B.7.1.3 and ADA/ABA 403.3

As Built Meas:	43	Quantity:	LF		
Description:	Driveway cross slope exceeds 2.0% (5.0% or more)				
As Built Desc:	8.5% cross slope				
Solution:	Provide min. 48" wide level walkway through driveway				
Bar. Severity:	4 Low Severity	Cost Estimate:	\$5,375.00	Status:	
Implementation Priority:	1	Facility Function:			
Implementation Phase:		Implementation Date:			
Official Responsible:

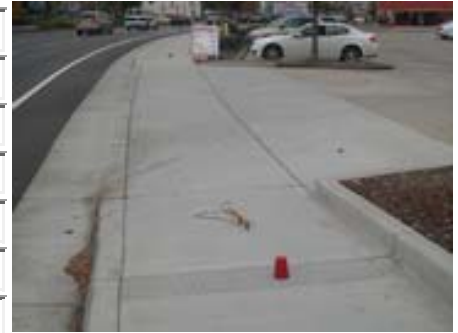
Barrier Type: Driveway - Existing (5.0% or more)

Code Ref: CBC 1133B.7.1.3 and ADA/ABA 403.3

As Built Meas: 60 Quantity: LF

Description: Driveway cross slope exceeds 2.0% (5.0% or more)

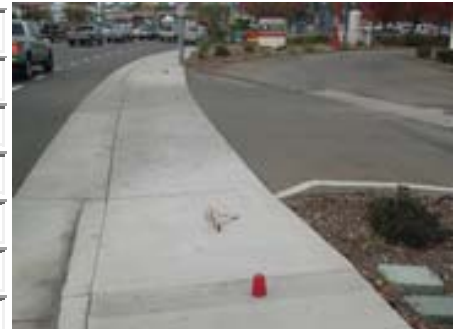
Barrier Type: Driveway - New Construction

Code Ref: CBC 1133B.7.1.3 and ADA/ABA 403.3

As Built Meas: 52 Quantity: LF

Description: Driveway cross/running slope exceeds 2.0%

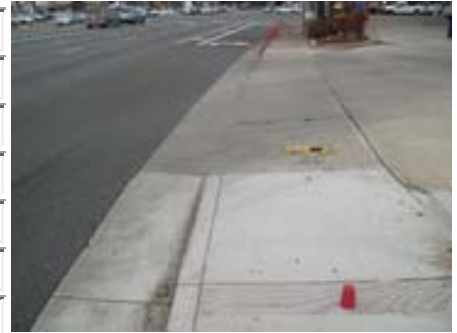
Field Date:	12/2/2010	Report Date:	12/2/2010	Barrier #:	2995
Location:	Greenback Ln - North				
X Coordinate:	-121.32015				
Y Coordinate:	38.67874				
Barrier Area:	Sidewalks				
Barrier Type:	Driveway - Existing (5.0% or more)				
Code Ref:	CBC 1133B.7.1.3 and ADA/ABA 403.3

As Built Meas:	52	Quantity:	LF		
Description:	Driveway cross slope exceeds 2.0% (5.0% or more)				
As Built Desc:	4.7% cross slope				
Solution:	Provide min. 48" wide level walkway through driveway				
Bar. Severity:	4 Low Severity	Cost Estimate:	\$6,500.00	Status:	
Implementation Priority:	1	Facility Function:			
Implementation Phase:		Implementation Date:			
Official Responsible:

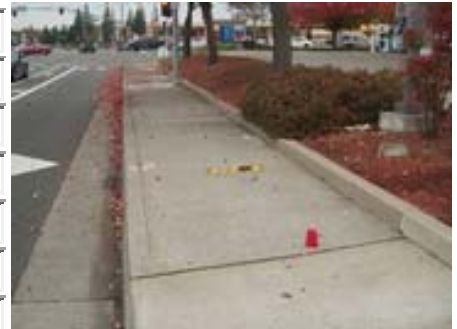
Field Date:	12/2/2010	Report Date:	12/2/2010	Barrier #:	2996
Location:	Greenback Ln - North				
X Coordinate:	-121.3202				
Y Coordinate:	38.67877				
Barrier Area:	Sidewalks				
Barrier Type:	Cross Slope - Existing (4.1% to 4.9%)				
Code Ref:	CBC 1133B.7.1.3 and ADA/ABA 403.3

As Built Meas:	103	Quantity:	LF		
Description:	Cross slope exceeds 2.0% (4.1% to 4.9%)				
As Built Desc:	4.3% cross slope				
Solution:	Demolish existing and construct new route				
Bar. Severity:	2 Recommended	Cost Estimate:	\$12,875.00	Status:	
Implementation Priority:	1	Facility Function:			
Implementation Phase:		Implementation Date:			
Official Responsible:

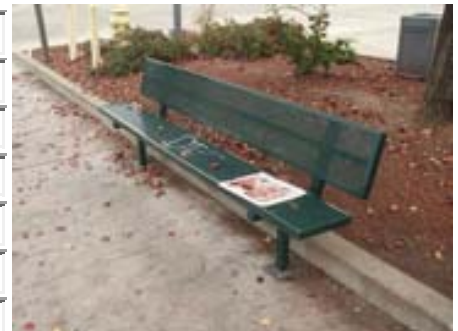
Field Date:	12/2/2010	Report Date:	12/2/2010	Barrier #:	2998A
Location:	Auburn Blvd - East				
X Coordinate:	-121.32014				
Y Coordinate:	38.67923				
Barrier Area:	Bus Stops and Shelters				
Barrier Type:	Bench Seat Depth				
Code Ref:	ADAAG 4.37.1 and ADA/ABA 903.4

As Built Meas:	1	Quantity:	EACH
Description:	Bench seat depth not 20" - 24" deep		
As Built Desc:	12-1/2" bench seat depth		
Solution:	Provide min. 1 accessible bench at bench stop		
Bar. Severity:	3 Hindrance	Cost Estimate:	\$775.00
Implementation Priority:	1	Facility Function:	
Implementation Phase:		Implementation Date:	
Official Responsible:

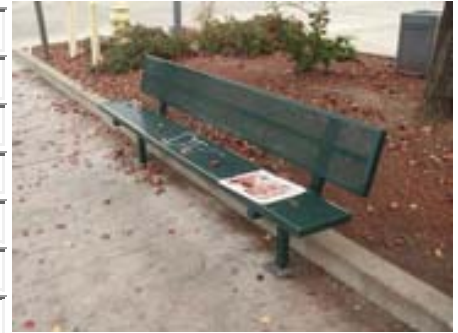
Field Date:	12/2/2010	Report Date:	12/2/2010	Barrier #:	2998B
Location:	Auburn Blvd - East				
X Coordinate:	-121.32014				
Y Coordinate:	38.67923				
Barrier Area:	Bus Stops and Shelters				
Barrier Type:	Bench Back Support				
Code Ref:	ADAAG 4.37.4 and ADA/ABA 903.4

As Built Meas:	1	Quantity:	EACH		
Description:	Bench has no back support of at least 18" high				
As Built Desc:	16" back support height				
Solution:	Provide min. 1 accessible bench at bench stop or shelter				
Bar. Severity:	3 Hindrance	Cost Estimate:	\$0.00	Status:	
Implementation Priority:	1	Facility Function:			
Implementation Phase:		Implementation Date:			
Official Responsible:

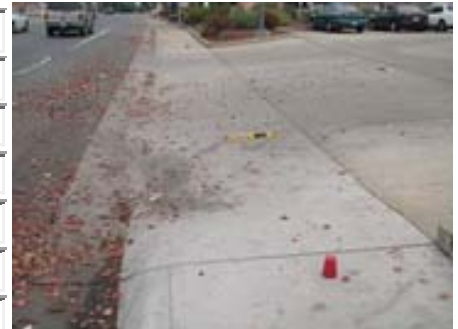
Field Date:	12/2/2010	Report Date:	12/2/2010	Barrier #:	2999
Location:	Auburn Blvd - East				
X Coordinate:	-121.32004				
Y Coordinate:	38.67929				
Barrier Area:	Sidewalks				
Barrier Type:	Driveway - Existing (5.0% or more)				
Code Ref:	CBC 1133B.7.1.3 and ADA/ABA 403.3

As Built Meas:	52	Quantity:	LF		
Description:	Driveway cross slope exceeds 2.0% (5.0% or more)				
As Built Desc:	5.8% cross slope, 10.0% running slope				
Solution:	Provide min. 48" wide level walkway through driveway				
Bar. Severity:	1 Necessary	Cost Estimate:	\$6,500.00	Status:	
Implementation Priority:	1	Facility Function:			
Implementation Phase:		Implementation Date:			
Official Responsible:

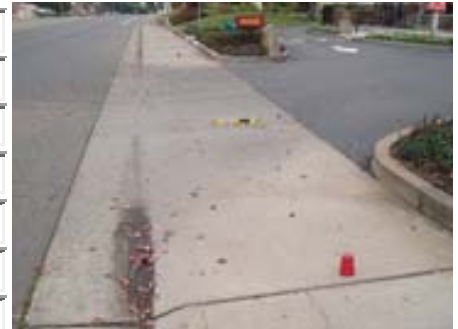
Field Date:	12/2/2010	Report Date:	12/2/2010	Barrier #:	3001
Location:	Auburn Blvd - East				
X Coordinate:	-121.31977				
Y Coordinate:	38.67948				
Barrier Area:	Sidewalks				
Barrier Type:	Driveway - Existing (4.1% to 4.9%)				
Code Ref:	CBC 1133B.7.1.3 and ADA/ABA 403.3

As Built Meas:	41	Quantity:	LF		
Description:	Driveway cross slope exceeds 2.0% (4.1% to 4.9%)				
As Built Desc:	4.1% cross slope				
Solution:	Provide min. 48" wide level walkway through driveway				
Bar. Severity:	3 Hinderance	Cost Estimate:	\$5,125.00	Status:	
Implementation Priority:	1	Facility Function:			
Implementation Phase:		Implementation Date:			
Official Responsible:

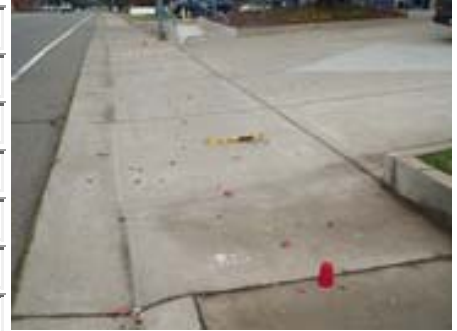
Field Date:	12/2/2010	Report Date:	12/2/2010	Barrier #:	3002
Location:	Auburn Blvd - East				
X Coordinate:	-121.31905				
Y Coordinate:	38.67996				
Barrier Area:	Sidewalks				
Barrier Type:	Driveway - Existing (5.0% or more)				
Code Ref:	CBC 1133B.7.1.3 and ADA/ABA 403.3

As Built Meas:	37	Quantity:	LF		
Description:	Driveway cross slope exceeds 2.0% (5.0% or more)				
As Built Desc:	5.9% cross slope				
Solution:	Provide min. 48" wide level walkway through driveway				
Bar. Severity:	4 Low Severity	Cost Estimate:	\$4,625.00	Status:	
Implementation Priority:	1	Facility Function:			
Implementation Phase:		Implementation Date:			
Official Responsible:

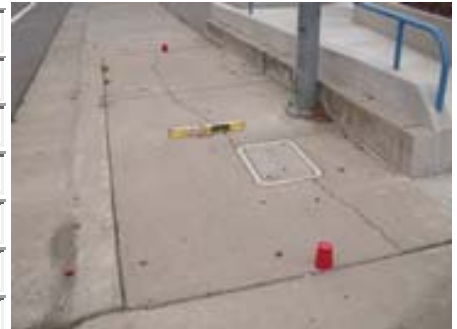
Field Date:	12/2/2010	Report Date:	12/2/2010	Barrier #:	3003
Location:	Auburn Blvd - East				
X Coordinate:	-121.31895				
Y Coordinate:	38.68004				
Barrier Area:	Sidewalks				
Barrier Type:	Cross Slope - Existing (4.1% to 4.9%)				
Code Ref:	CBC 1133B.7.1.3 and ADA/ABA 403.3

As Built Meas:	16	Quantity:	LF		
Description:	Cross slope exceeds 2.0% (4.1% to 4.9%)				
As Built Desc:	4.3% cross slope				
Solution:	Demolish existing and construct new route				
Bar. Severity:	2 Recommended	Cost Estimate:	\$2,000.00	Status:	
Implementation Priority:	1	Facility Function:			
Implementation Phase:		Implementation Date:			
Official Responsible:

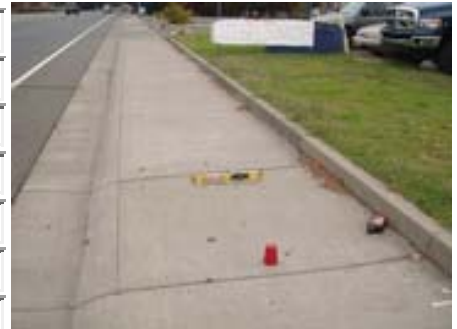
Field Date:	12/2/2010	Report Date:	12/2/2010	Barrier #:	3005
Location:	Auburn Blvd - East				
X Coordinate:	-121.31875				
Y Coordinate:	38.68016				
Barrier Area:	Sidewalks				
Barrier Type:	Cross Slope - Existing (3.1% to 4.0%)				
Code Ref:	CBC 1133B.7.1.3 and ADA/ABA 403.3

As Built Meas:	60	Quantity:	LF		
Description:	Cross slope exceeds 2.0% (3.1% to 4.0%)				
As Built Desc:	3.5% cross slope				
Solution:	Demolish existing and construct new route				
Bar. Severity:	3 Hinderance	Cost Estimate:	\$7,500.00	Status:	
Implementation Priority:	1	Facility Function:			
Implementation Phase:		Implementation Date:			
Official Responsible:

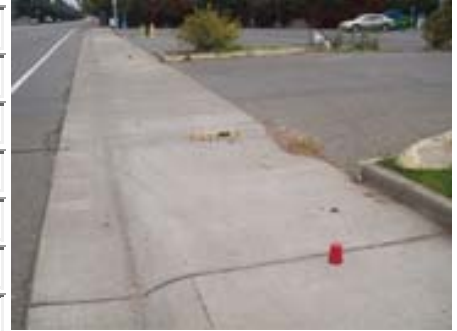
Field Date:	12/2/2010	Report Date:	12/2/2010	Barrier #:	3006
Location:	Auburn Blvd - East				
X Coordinate:	-121.31856				
Y Coordinate:	38.68026				
Barrier Area:	Sidewalks				
Barrier Type:	Driveway - Existing (3.1% to 4.0%)				
Code Ref:	CBC 1133B.7.1.3 and ADA/ABA 403.3

As Built Meas:	45	Quantity:	LF		
Description:	Driveway cross slope exceeds 2.0% (3.1% to 4.0%)				
As Built Desc:	3.8% cross slope				
Solution:	Provide min. 48" wide level walkway through driveway				
Bar. Severity:	2 Recommended	Cost Estimate:	\$5,625.00	Status:	
Implementation Priority:	1	Facility Function:			
Implementation Phase:		Implementation Date:			
Official Responsible:

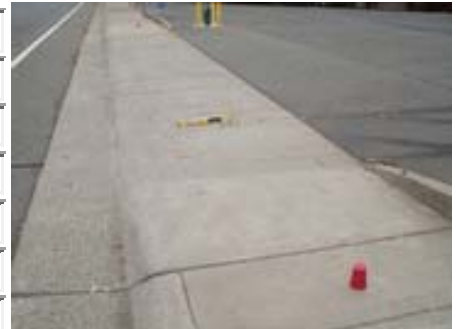
Field Date:	12/2/2010	Report Date:	12/2/2010	Barrier #:	3007
Location:	Auburn Blvd - East				
X Coordinate:	-121.31843				
Y Coordinate:	38.68035				
Barrier Area:	Sidewalks				
Barrier Type:	Driveway - Existing (5.0% or more)				
Code Ref:	CBC 1133B.7.1.3 and ADA/ABA 403.3

As Built Meas:	51	Quantity:	LF		
Description:	Driveway cross slope exceeds 2.0% (5.0% or more)				
As Built Desc:	5.7% cross slope				
Solution:	Provide min. 48" wide level walkway through driveway				
Bar. Severity:	4 Low Severity	Cost Estimate:	\$6,375.00	Status:	
Implementation Priority:	1	Facility Function:			
Implementation Phase:		Implementation Date:			
Official Responsible:

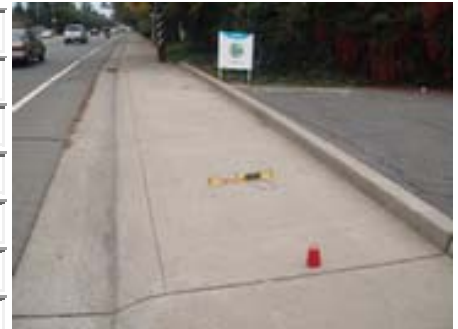
Field Date:	12/2/2010	Report Date:	12/2/2010	Barrier #:	3009
Location:	Auburn Blvd - East				
X Coordinate:	-121.31812				
Y Coordinate:	38.68058				
Barrier Area:	Sidewalks				
Barrier Type:	Cross Slope - Existing (4.1% to 4.9%)				
Code Ref:	CBC 1133B.7.1.3 and ADA/ABA 403.3

As Built Meas:	46	Quantity:	LF		
Description:	Cross slope exceeds 2.0% (4.1% to 4.9%)				
As Built Desc:	4.1% cross slope				
Solution:	Demolish existing and construct new route				
Bar. Severity:	2 Recommended	Cost Estimate:	\$5,750.00	Status:	
Implementation Priority:	1	Facility Function:			
Implementation Phase:		Implementation Date:			
Official Responsible:

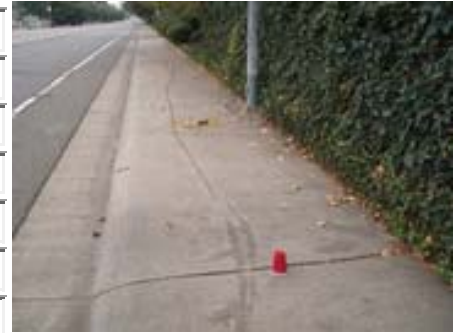
Field Date:	12/2/2010	Report Date:	12/2/2010	Barrier #:	3010
Location:	Auburn Blvd - East				
X Coordinate:	-121.31786				
Y Coordinate:	38.68076				
Barrier Area:	Sidewalks				
Barrier Type:	Cross Slope - Existing (3.1% to 4.0%)				
Code Ref:	CBC 1133B.7.1.3 and ADA/ABA 403.3

As Built Meas:	344	Quantity:	LF		
Description:	Cross slope exceeds 2.0% (3.1% to 4.0%)				
As Built Desc:	3.9% cross slope				
Solution:	Demolish existing and construct new route				
Bar. Severity:	3 Hinderance	Cost Estimate:	\$43,000.00	Status:	
Implementation Priority:	1	Facility Function:			
Implementation Phase:		Implementation Date:			
Official Responsible:

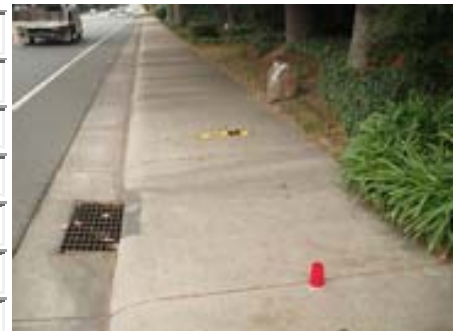
Field Date:	12/2/2010	Report Date:	12/2/2010	Barrier #:	3011A
Location:	Auburn Blvd - East				
X Coordinate:	-121.31675				
Y Coordinate:	38.68146				
Barrier Area:	Sidewalks				
Barrier Type:	Cross Slope - Existing (3.1% to 4.0%)				
Code Ref:	CBC 1133B.7.1.3 and ADA/ABA 403.3

As Built Meas:	347	Quantity:	LF		
Description:	Cross slope exceeds 2.0% (3.1% to 4.0%)				
As Built Desc:	3.5% cross slope				
Solution:	Demolish existing and construct new route				
Bar. Severity:	3 Hinderance	Cost Estimate:	\$43,375.00	Status:	
Implementation Priority:	1	Facility Function:			
Implementation Phase:		Implementation Date:			
Official Responsible:

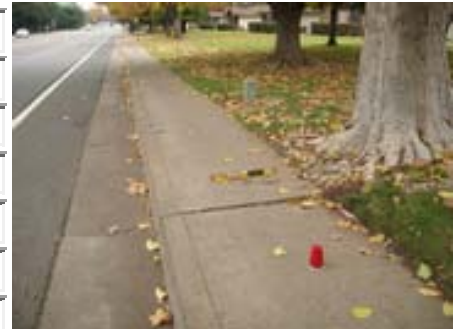
Field Date:	12/2/2010	Report Date:	12/2/2010	Barrier #:	3012A
Location:	Auburn Blvd - East				
X Coordinate:	-121.31573				
Y Coordinate:	38.68217				
Barrier Area:	Sidewalks				
Barrier Type:	Cross Slope - Existing (3.1% to 4.0%)				
Code Ref:	CBC 1133B.7.1.3 and ADA/ABA 403.3

As Built Meas:	107	Quantity:	LF		
Description:	Cross slope exceeds 2.0% (3.1% to 4.0%)				
As Built Desc:	3.7% cross slope				
Solution:	Demolish existing and construct new route				
Bar. Severity:	3 Hinderance	Cost Estimate:	\$13,375.00	Status:	
Implementation Priority:	1	Facility Function:			
Implementation Phase:		Implementation Date:			
Official Responsible:

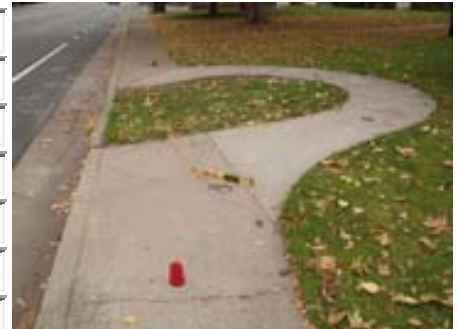
Field Date:	12/2/2010	Report Date:	12/2/2010	Barrier #:	3013A
Location:	Auburn Blvd - East				
X Coordinate:	-121.31516				
Y Coordinate:	38.68249				
Barrier Area:	Sidewalks				
Barrier Type:	Cross Slope - Existing (5.0% or more)				
Code Ref:	CBC 1133B.7.1.3 and ADA/ABA 403.3

As Built Meas:	55	Quantity:	LF		
Description:	Cross slope exceeds 2.0% (5.0% or more)				
As Built Desc:	6.7% cross slope				
Solution:	Demolish existing and construct new route				
Bar. Severity:	1 Necessary	Cost Estimate:	\$6,875.00	Status:	
Implementation Priority:	1	Facility Function:			
Implementation Phase:		Implementation Date:			
Official Responsible:

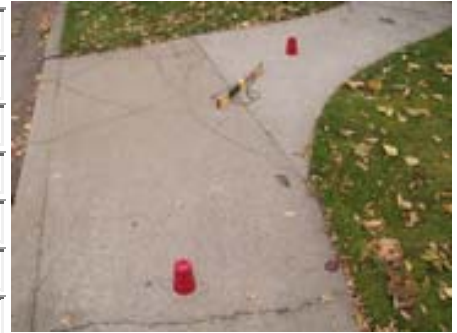
Field Date:	12/2/2010	Report Date:	12/2/2010	Barrier #:	3013B
Location:	Auburn Blvd - East				
X Coordinate:	-121.31516				
Y Coordinate:	38.68249				
Barrier Area:	Sidewalks				
Barrier Type:	Running Slope (Existing)				
Code Ref:	CBC 1133B.7.3 and ADA/ABA 403.3

As Built Meas:	4	Quantity:	LF
Description:	Running slope exceeds 5.0%		
As Built Desc:	6.5% running slope		
Solution:	No remediation where sidewalk sloped as roadway		
Bar. Severity:	5 Technically Infeasible	Cost Estimate:	\$0.00
Implementation Priority:	1	Facility Function:	
Implementation Phase:		Implementation Date:	
Official Responsible:

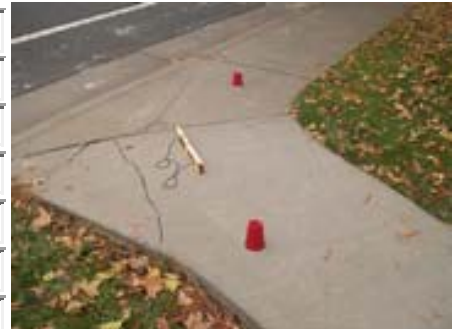
Field Date:	12/2/2010	Report Date:	12/2/2010	Barrier #:	3013C
Location:	Auburn Blvd - East				
X Coordinate:	-121.3151				
Y Coordinate:	38.6825				
Barrier Area:	Sidewalks				
Barrier Type:	Running Slope (Existing)				
Code Ref:	CBC 1133B.7.3 and ADA/ABA 403.3

As Built Meas:	4	Quantity:	LF
Description:	Running slope exceeds 5.0%		
As Built Desc:	9.7% running slope		
Solution:	No remediation where sidewalk sloped as roadway		
Bar. Severity:	5 Technically Infeasible	Cost Estimate:	\$0.00
Implementation Priority:	1	Facility Function:	
Implementation Phase:		Implementation Date:	
Official Responsible:

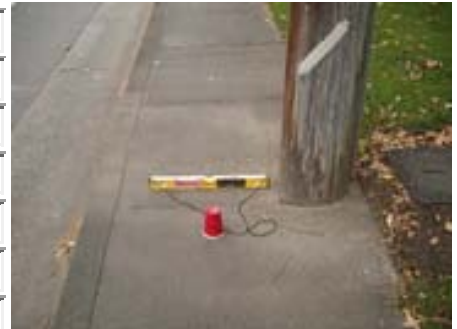
Field Date:	12/2/2010	Report Date:	12/2/2010	Barrier #:	3014
Location:	Auburn Blvd - East				
X Coordinate:	-121.31448				
Y Coordinate:	38.68287				
Barrier Area:	Sidewalks				
Barrier Type:	Clear Width - Existing ( $\leq 31"$ or less)				
Code Ref:	CBC 1133B.7.1

As Built Meas:	4	Quantity:	LF	
Description:	Pedestrian route is not min. 48" wide ( $\leq 31"$ or less)			
As Built Desc:	28" clear width due to pole			
Solution:	Demolish existing and construct new route			
Bar. Severity:	1 Necessary	Cost Estimate:	\$500.00	Status:
Implementation Priority:	1	Facility Function:		
Implementation Phase:		Implementation Date:		
Official Responsible:

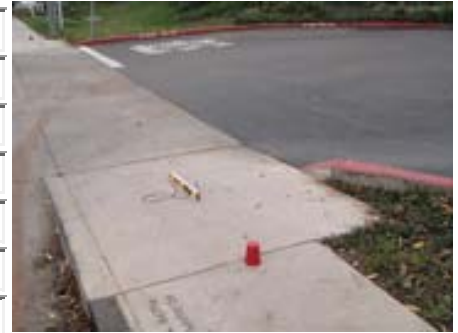
Field Date:	12/2/2010	Report Date:	12/2/2010	Barrier #:	3015
Location:	Auburn Blvd - East				
X Coordinate:	-121.31409				
Y Coordinate:	38.68315				
Barrier Area:	Sidewalks				
Barrier Type:	Running Slope (Existing)				
Code Ref:	CBC 1133B.7.3 and ADA/ABA 403.3

As Built Meas:	5	Quantity:	LF		
Description:	Running slope exceeds 5.0%				
As Built Desc:	7.1% running slope				
Solution:	No remediation where sidewalk sloped as roadway				
Bar. Severity:	5 Technically Infeasible	Cost Estimate:	\$0.00	Status:	
Implementation Priority:	1	Facility Function:			
Implementation Phase:		Implementation Date:			
Official Responsible:

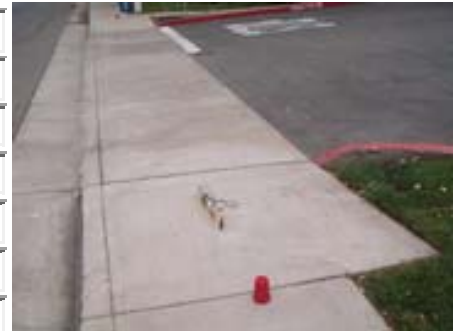
Field Date:	12/2/2010	Report Date:	12/2/2010	Barrier #:	3016
Location:	Auburn Blvd - East				
X Coordinate:	-121.31358				
Y Coordinate:	38.68346				
Barrier Area:	Sidewalks				
Barrier Type:	Running Slope (Existing)				
Code Ref:	CBC 1133B.7.3 and ADA/ABA 403.3

As Built Meas:	5	Quantity:	LF		
Description:	Running slope exceeds 5.0%				
As Built Desc:	7.7% running slope				
Solution:	No remediation where sidewalk sloped as roadway				
Bar. Severity:	5 Technically Infeasible	Cost Estimate:	\$0.00	Status:	
Implementation Priority:	1	Facility Function:			
Implementation Phase:		Implementation Date:			
Official Responsible:

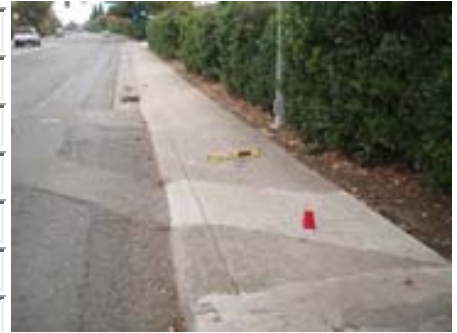
Field Date:	12/2/2010	Report Date:	12/2/2010	Barrier #:	3017
Location:	Auburn Blvd - East				
X Coordinate:	-121.3131				
Y Coordinate:	38.6837				
Barrier Area:	Sidewalks				
Barrier Type:	Cross Slope - Existing (5.0% or more)				
Code Ref:	CBC 1133B.7.1.3 and ADA/ABA 403.3

As Built Meas:	128	Quantity:	LF		
Description:	Cross slope exceeds 2.0% (5.0% or more)				
As Built Desc:	6.3% cross slope				
Solution:	Demolish existing and construct new route				
Bar. Severity:	1 Necessary	Cost Estimate:	\$16,000.00	Status:	
Implementation Priority:	1	Facility Function:			
Implementation Phase:		Implementation Date:			
Official Responsible:

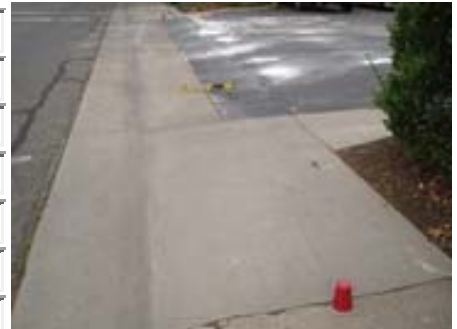
Field Date:	12/2/2010	Report Date:	12/2/2010	Barrier #:	3018
Location:	Auburn Blvd - East				
X Coordinate:	-121.31273				
Y Coordinate:	38.68396				
Barrier Area:	Sidewalks				
Barrier Type:	Cross Slope - Existing (5.0% or more)				
Code Ref:	CBC 1133B.7.1.3 and ADA/ABA 403.3

As Built Meas:	47	Quantity:	LF		
Description:	Cross slope exceeds 2.0% (5.0% or more)				
As Built Desc:	6.6% cross slope				
Solution:	Demolish existing and construct new route				
Bar. Severity:	1 Necessary	Cost Estimate:	\$5,875.00	Status:	
Implementation Priority:	1	Facility Function:			
Implementation Phase:		Implementation Date:			
Official Responsible:

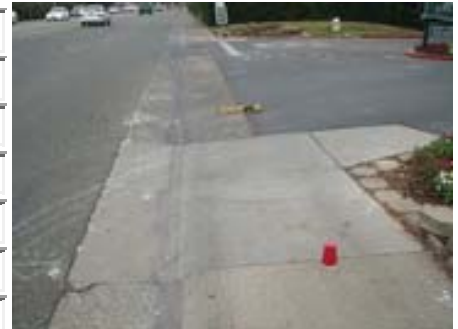
Field Date:	12/2/2010	Report Date:	12/2/2010	Barrier #:	3020
Location:	Auburn Blvd - East				
X Coordinate:	-121.31122				
Y Coordinate:	38.68496				
Barrier Area:	Sidewalks				
Barrier Type:	Driveway - Existing (5.0% or more)				
Code Ref:	CBC 1133B.7.1.3 and ADA/ABA 403.3

As Built Meas:	48	Quantity:	LF		
Description:	Driveway cross slope exceeds 2.0% (5.0% or more)				
As Built Desc:	8.3% cross slope				
Solution:	Provide min. 48" wide level walkway through driveway				
Bar. Severity:	4 Low Severity	Cost Estimate:	\$6,000.00	Status:	
Implementation Priority:	1	Facility Function:			
Implementation Phase:		Implementation Date:			
Official Responsible:

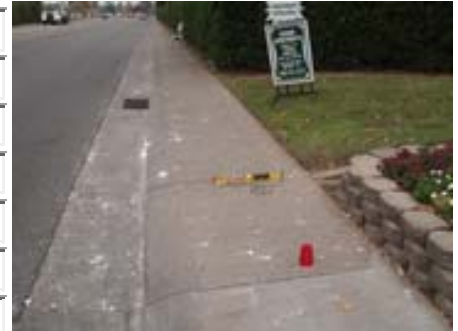
Field Date:	12/2/2010	Report Date:	12/2/2010	Barrier #:	3021
Location:	Auburn Blvd - East				
X Coordinate:	-121.31108				
Y Coordinate:	38.68506				
Barrier Area:	Sidewalks				
Barrier Type:	Cross Slope - Existing (5.0% or more)				
Code Ref:	CBC 1133B.7.1.3 and ADA/ABA 403.3

As Built Meas:	70	Quantity:	LF
Description:	Cross slope exceeds 2.0% (5.0% or more)		
As Built Desc:	5.6% cross slope		
Solution:	Demolish existing and construct new route		
Bar. Severity:	1 Necessary	Cost Estimate:	\$8,750.00
Implementation Priority:	1	Facility Function:	
Implementation Phase:		Implementation Date:	
Official Responsible:

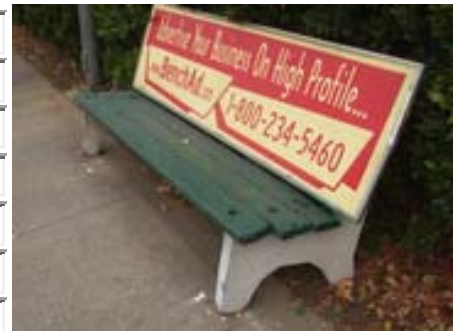
Field Date:	12/2/2010	Report Date:	12/2/2010	Barrier #:	3022A
Location:	Auburn Blvd - East				
X Coordinate:	-121.31092				
Y Coordinate:	38.68523				
Barrier Area:	Bus Stops and Shelters				
Barrier Type:	Bench Seat Depth				
Code Ref:	ADAAG 4.37.1 and ADA/ABA 903.4

As Built Meas:	1	Quantity:	EACH
Description:	Bench seat depth not 20" - 24" deep		
As Built Desc:	16" bench seat depth		
Solution:	Provide min. 1 accessible bench at bench stop		
Bar. Severity:	3 Hindrance	Cost Estimate:	\$775.00
Implementation Priority:	1	Facility Function:	
Implementation Phase:		Implementation Date:	
Official Responsible:

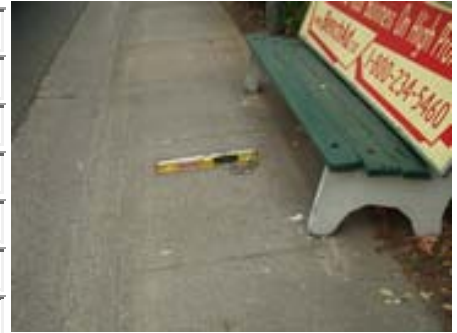
Field Date:	12/2/2010	Report Date:	12/2/2010	Barrier #:	3022B
Location:	Auburn Blvd - East				
X Coordinate:	-121.31092				
Y Coordinate:	38.68523				
Barrier Area:	Bus Stops and Shelters				
Barrier Type:	Cross Slope - Existing (5.0% or more)				
Code Ref:	CBC 1121B.2.1 and ADAAG 10.2.1(1)

As Built Meas:	8	Quantity:	LF		
Description:	Cross slope at bus pad or shelter exceeds 2.0% (5.0% or more)				
As Built Desc:	5.4% cross slope				
Solution:	Demolish existing and construct new bus pad or shelter pad				
Bar. Severity:	1 Necessary	Cost Estimate:	\$0.00	Status:	
Implementation Priority:	1	Facility Function:			
Implementation Phase:		Implementation Date:			
Official Responsible:

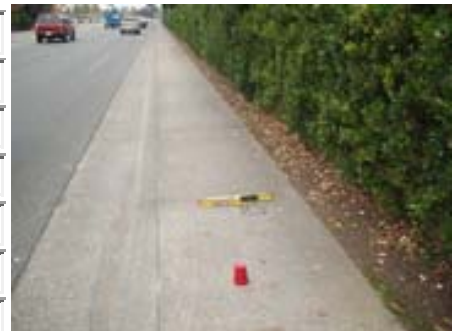
Field Date:	12/2/2010	Report Date:	12/2/2010	Barrier #:	3023
Location:	Auburn Blvd - East				
X Coordinate:	-121.31086				
Y Coordinate:	38.68525				
Barrier Area:	Sidewalks				
Barrier Type:	Cross Slope - Existing (3.1% to 4.0%)				
Code Ref:	CBC 1133B.7.1.3 and ADA/ABA 403.3

As Built Meas:	490	Quantity:	LF		
Description:	Cross slope exceeds 2.0% (3.1% to 4.0%)				
As Built Desc:	3.9% cross slope				
Solution:	Demolish existing and construct new route				
Bar. Severity:	3 Hinderance	Cost Estimate:	\$61,250.00	Status:	
Implementation Priority:	1	Facility Function:			
Implementation Phase:		Implementation Date:			
Official Responsible:

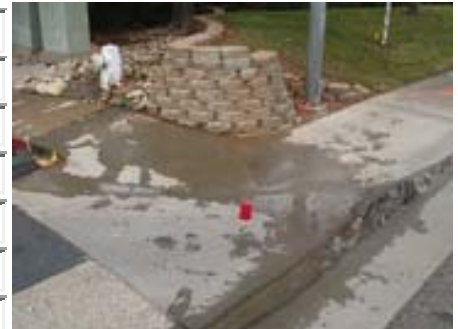
Field Date:	12/2/2010	Report Date:	12/2/2010	Barrier #:	3025A
Location:	Van Maren Ln and Arcade Creek - Corner A				
X Coordinate:	-121.3092				
Y Coordinate:	38.68424				
Barrier Area:	Curb Ramps				
Barrier Type:	12" Grooves - Existing (>5.0%)				
Code Ref:	CBC 1127B.5.6

As Built Meas:	1	Quantity:	EACH	
Description:	12" grooves at top of curb ramp are not level (>5.0%)			
As Built Desc:	7.3% at 12" grooves			
Solution:	Demolish existing and construct new curb ramp			
Bar. Severity:	1 Necessary	Cost Estimate:	\$2,500.00	Status:
Implementation Priority:	1	Facility Function:		
Implementation Phase:		Implementation Date:		
Official Responsible:

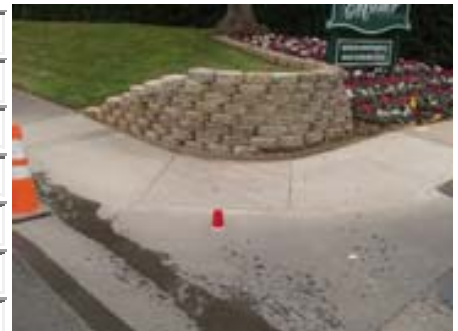
Field Date:	12/2/2010	Report Date:	12/2/2010	Barrier #:	3026A
Location:	Van Maren Ln and Arcade Creek - Corner D				
X Coordinate:	-121.3092				
Y Coordinate:	38.68413				
Barrier Area:	Curb Ramps				
Barrier Type:	Running Slope - Existing (9.5% or more)				
Code Ref:	CBC 1127B.5.3 and ADA/ABA 406.1

As Built Meas:	1	Quantity:	EACH	
Description:	Ramp run cross slope exceeds 2.0% (9.5% or more)			
As Built Desc:	10.9% running slope			
Solution:	Demolish existing and construct new curb ramp			
Bar. Severity:	1 Necessary	Cost Estimate:	\$2,500.00	Status:
Implementation Priority:	1	Facility Function:		
Implementation Phase:		Implementation Date:		
Official Responsible:

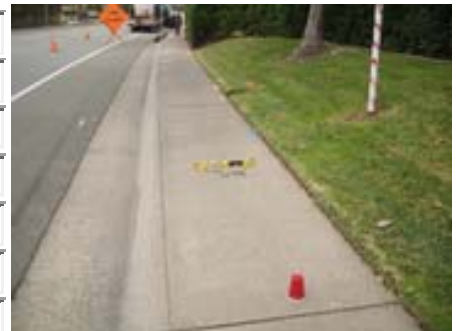
Field Date:	12/2/2010	Report Date:	12/2/2010	Barrier #:	3027
Location:	Van Maren Ln - West				
X Coordinate:	-121.30923				
Y Coordinate:	38.68401				
Barrier Area:	Sidewalks				
Barrier Type:	Cross Slope - Existing (3.1% to 4.0%)				
Code Ref:	CBC 1133B.7.1.3 and ADA/ABA 403.3

As Built Meas:	190	Quantity:	LF		
Description:	Cross slope exceeds 2.0% (3.1% to 4.0%)				
As Built Desc:	4.0% cross slope				
Solution:	Demolish existing and construct new route				
Bar. Severity:	3 Hinderance	Cost Estimate:	\$23,750.00	Status:	
Implementation Priority:	1	Facility Function:			
Implementation Phase:		Implementation Date:			
Official Responsible:

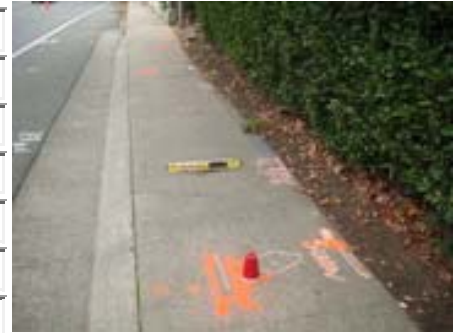
Field Date:	12/2/2010	Report Date:	12/2/2010	Barrier #:	3028A
Location:	Van Maren Ln - West				
X Coordinate:	-121.3095				
Y Coordinate:	38.68333				
Barrier Area:	Sidewalks				
Barrier Type:	Cross Slope - Existing (5.0% or more)				
Code Ref:	CBC 1133B.7.1.3 and ADA/ABA 403.3

As Built Meas:	48	Quantity:	LF		
Description:	Cross slope exceeds 2.0% (5.0% or more)				
As Built Desc:	7.8% cross slope				
Solution:	Demolish existing and construct new route				
Bar. Severity:	1 Necessary	Cost Estimate:	\$6,000.00	Status:	
Implementation Priority:	1	Facility Function:			
Implementation Phase:		Implementation Date:			
Official Responsible:

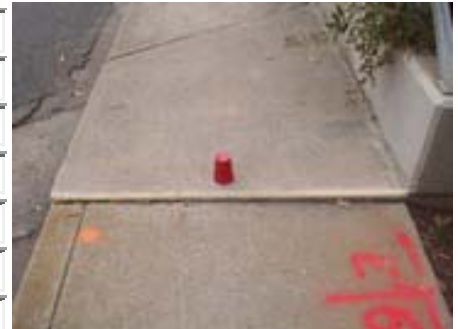
Field Date:	12/2/2010	Report Date:	12/2/2010	Barrier #:	3028B
Location:	Van Maren Ln - West				
X Coordinate:	-121.30954				
Y Coordinate:	38.68318				
Barrier Area:	Sidewalks				
Barrier Type:	Abrupt Change in Level - > 1/2"				
Code Ref:	CBC 1133B.7.1 and ADA/ABA 303.3

As Built Meas:	4	Quantity:	LF		
Description:	Change in level greater than 1/2"				
As Built Desc:	1/2" lip in sidewalk surface				
Solution:	Grind or repair sidewalk to remove trip hazard				
Bar. Severity:	1 Necessary	Cost Estimate:	\$1,000.00	Status:	
Implementation Priority:	1	Facility Function:			
Implementation Phase:		Implementation Date:			
Official Responsible:

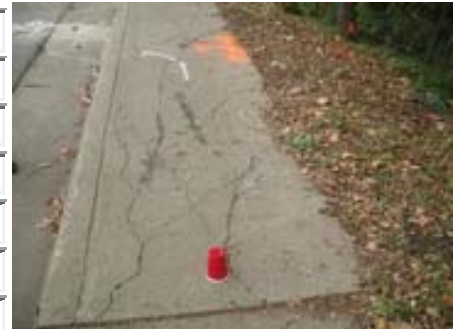
Field Date:	12/2/2010	Report Date:	12/2/2010	Barrier #:	3030A
Location:	Van Maren Ln - West				
X Coordinate:	-121.30975				
Y Coordinate:	38.68272				
Barrier Area:	Sidewalks				
Barrier Type:	Surface Condition - Damaged				
Code Ref:	CBC 1133B.7.1 and ADA/ABA 302.1

As Built Meas:	16	Quantity:	LF
Description:	Surface is not firm and stable (cracked, broken or loose soil, etc.)		
As Built Desc:	Cracked concrete		
Solution:	Repair surface to make firm and stable		
Bar. Severity:	1 Necessary	Cost Estimate:	\$2,000.00
Implementation Priority:	1	Facility Function:	
Implementation Phase:		Implementation Date:	
Official Responsible:

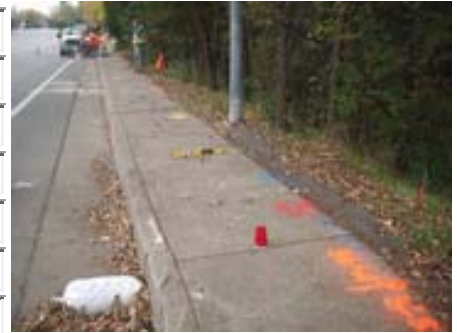
Field Date:	12/2/2010	Report Date:	12/2/2010	Barrier #:	3030B
Location:	Van Maren Ln - West				
X Coordinate:	-121.30974				
Y Coordinate:	38.68278				
Barrier Area:	Sidewalks				
Barrier Type:	Cross Slope - Existing (3.1% to 4.0%)				
Code Ref:	CBC 1133B.7.1.3 and ADA/ABA 403.3

As Built Meas:	20	Quantity:	LF		
Description:	Cross slope exceeds 2.0% (3.1% to 4.0%)				
As Built Desc:	3.7% cross slope				
Solution:	Demolish existing and construct new route				
Bar. Severity:	3 Hinderance	Cost Estimate:	\$2,500.00	Status:	
Implementation Priority:	1	Facility Function:			
Implementation Phase:		Implementation Date:			
Official Responsible:

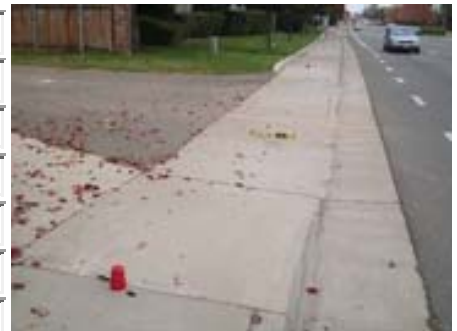
Field Date:	12/2/2010	Report Date:	12/2/2010	Barrier #:	3031
Location:	Greenback Lane - North				
X Coordinate:	-121.30981				
Y Coordinate:	38.67828				
Barrier Area:	Sidewalks				
Barrier Type:	Driveway - Existing (3.1% to 4.0%)				
Code Ref:	CBC 1133B.7.1.3 and ADA/ABA 403.3

As Built Meas:	30	Quantity:	LF		
Description:	Driveway cross slope exceeds 2.0% (3.1% to 4.0%)				
As Built Desc:	3.5% cross slope, 8.8% running slope				
Solution:	Provide min. 48" wide level walkway through driveway				
Bar. Severity:	1 Necessary	Cost Estimate:	\$3,750.00	Status:	
Implementation Priority:	1	Facility Function:			
Implementation Phase:		Implementation Date:			
Official Responsible:

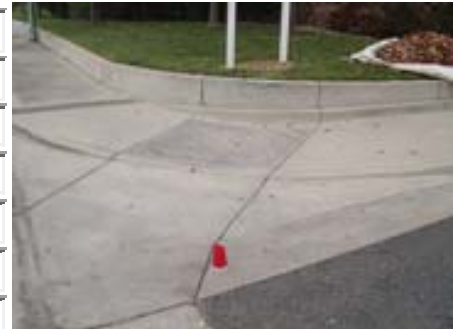
Field Date:	12/2/2010	Report Date:	12/2/2010	Barrier #:	3032B
Location:	Greenback Ln - North - Corner A				
X Coordinate:	-121.30904				
Y Coordinate:	38.67827				
Barrier Area:	Curb Ramps				
Barrier Type:	Running Slope - Existing (9.5% or more)				
Code Ref:	CBC 1127B.5.3 and ADA/ABA 406.1

As Built Meas:	1	Quantity:	EACH		
Description:	Ramp run cross slope exceeds 2.0% (9.5% or more)				
As Built Desc:	13.8% running slope				
Solution:	Demolish existing and construct new curb ramp				
Bar. Severity:	1 Necessary	Cost Estimate:	\$0.00	Status:	
Implementation Priority:	1	Facility Function:			
Implementation Phase:		Implementation Date:			
Official Responsible:

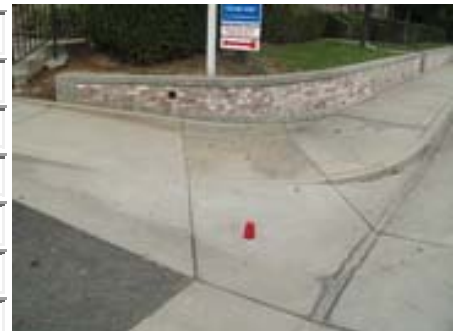
Field Date:	12/2/2010	Report Date:	12/2/2010	Barrier #:	3033B
Location:	Greenback Ln - North - Corner B				
X Coordinate:	-121.30893				
Y Coordinate:	38.67826				
Barrier Area:	Curb Ramps				
Barrier Type:	Running Slope - Existing (9.5% or more)				
Code Ref:	CBC 1127B.5.3 and ADA/ABA 406.1

As Built Meas:	1	Quantity:	EACH		
Description:	Ramp run cross slope exceeds 2.0% (9.5% or more)				
As Built Desc:	12.9% running slope				
Solution:	Demolish existing and construct new curb ramp				
Bar. Severity:	1 Necessary	Cost Estimate:	\$0.00	Status:	
Implementation Priority:	1	Facility Function:			
Implementation Phase:		Implementation Date:			
Official Responsible:

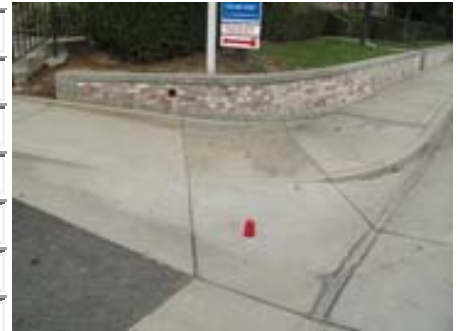
Field Date:	12/2/2010	Report Date:	12/2/2010	Barrier #:	3033D
Location:	Greenback Ln - North - Corner B				
X Coordinate:	-121.30893				
Y Coordinate:	38.67826				
Barrier Area:	Curb Ramps				
Barrier Type:	Transition into Roadway - Existing (8.3% or more)				
Code Ref:	CBC 1127B.5.3 and ADA/ABA 406.2

As Built Meas:	16	Quantity:	SF		
Description:	Transition from gutter into roadway slope exceeds 5.0% (8.3% or more)				
As Built Desc:	6.7% transition slope				
Solution:	Demolish existing and construct new transition				
Bar. Severity:	1 Necessary	Cost Estimate:	\$0.00	Status:	
Implementation Priority:	1	Facility Function:			
Implementation Phase:		Implementation Date:			
Official Responsible:

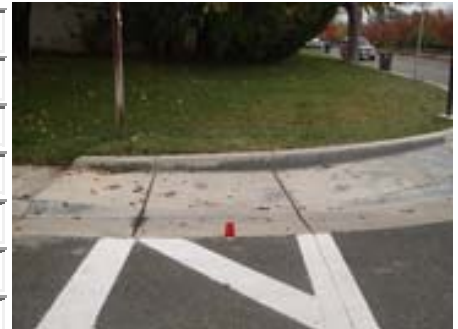
Field Date:	12/2/2010	Report Date:	12/2/2010	Barrier #:	3036A
Location:	Greenback Ln and Paris St - Corner B				
X Coordinate:	-121.30788				
Y Coordinate:	38.67842				
Barrier Area:	Curb Ramps				
Barrier Type:	12" Grooves - Existing (4.1% to 4.9%)				
Code Ref:	CBC 1127B.5.6

As Built Meas:	1	Quantity:	EACH	
Description:	12" grooves at top of curb ramp are not level (4.1% to 4.9%)			
As Built Desc:	4.5% at 12" grooves			
Solution:	Demolish existing and construct new curb ramp			
Bar. Severity:	2 Recommended	Cost Estimate:	\$2,500.00	Status:
Implementation Priority:	1	Facility Function:		
Implementation Phase:		Implementation Date:		
Official Responsible:

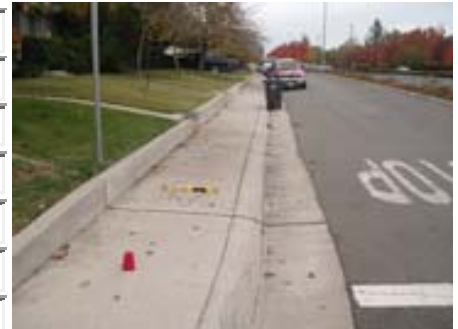
Field Date:	12/2/2010	Report Date:	12/2/2010	Barrier #:	3037
Location:	Greenback Ln - North				
X Coordinate:	-121.30778				
Y Coordinate:	38.67838				
Barrier Area:	Sidewalks				
Barrier Type:	Cross Slope - Existing (5.0% or more)				
Code Ref:	CBC 1133B.7.1.3 and ADA/ABA 403.3

As Built Meas:	840	Quantity:	LF		
Description:	Cross slope exceeds 2.0% (5.0% or more)				
As Built Desc:	5.3% cross slope				
Solution:	Demolish existing and construct new route				
Bar. Severity:	1 Necessary	Cost Estimate:	\$105,000.00	Status:	
Implementation Priority:	1	Facility Function:			
Implementation Phase:		Implementation Date:			
Official Responsible:

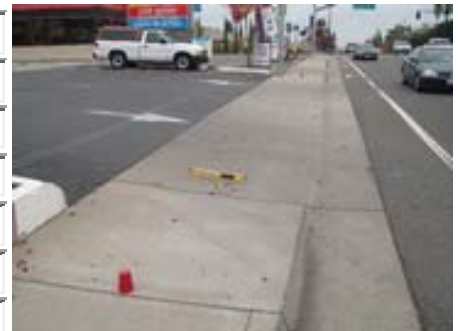
Field Date:	12/2/2010	Report Date:	12/2/2010	Barrier #:	3039
Location:	Greenback Ln - North				
X Coordinate:	-121.30429				
Y Coordinate:	38.67832				
Barrier Area:	Sidewalks				
Barrier Type:	Driveway - Existing (5.0% or more)				
Code Ref:	CBC 1133B.7.1.3 and ADA/ABA 403.3

As Built Meas:	48	Quantity:	LF
Description:	Driveway cross slope exceeds 2.0% (5.0% or more)		
As Built Desc:	7.7% cross slope		
Solution:	Provide min. 48" wide level walkway through driveway		
Bar. Severity:	4 Low Severity	Cost Estimate:	\$6,000.00
Implementation Priority:	1	Facility Function:	
Implementation Phase:		Implementation Date:	
Official Responsible:

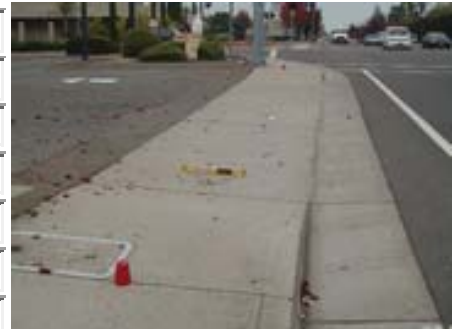
Field Date:	12/2/2010	Report Date:	12/2/2010	Barrier #:	3041
Location:	Greenback Ln - North				
X Coordinate:	-121.30383				
Y Coordinate:	38.67832				
Barrier Area:	Sidewalks				
Barrier Type:	Driveway - New Construction				
Code Ref:	CBC 1133B.7.1.3 and ADA/ABA 403.3

As Built Meas:	48	Quantity:	LF		
Description:	Driveway cross/running slope exceeds 2.0%				
As Built Desc:	3.4% cross slope, 9.2% running slope				
Solution:	Provide min. 48" wide level walkway through driveway				
Bar. Severity:	1 Necessary	Cost Estimate:	\$6,000.00	Status:	
Implementation Priority:	1	Facility Function:			
Implementation Phase:		Implementation Date:			
Official Responsible:

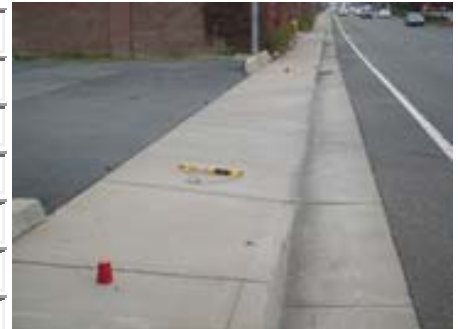
Field Date:	12/2/2010	Report Date:	12/2/2010	Barrier #:	3043
Location:	Greenback Ln - North				
X Coordinate:	-121.30229				
Y Coordinate:	38.67837				
Barrier Area:	Sidewalks				
Barrier Type:	Driveway - Existing (5.0% or more)				
Code Ref:	CBC 1133B.7.1.3 and ADA/ABA 403.3

As Built Meas:	43	Quantity:	LF		
Description:	Driveway cross slope exceeds 2.0% (5.0% or more)				
As Built Desc:	8.5% cross slope				
Solution:	Provide min. 48" wide level walkway through driveway				
Bar. Severity:	4 Low Severity	Cost Estimate:	\$5,375.00	Status:	
Implementation Priority:	1	Facility Function:			
Implementation Phase:		Implementation Date:			
Official Responsible:

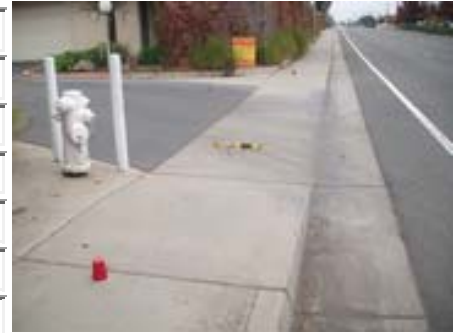
Field Date:	12/3/2010	Report Date:	12/3/2010	Barrier #:	3043
Location:	Greenback Ln - North				
X Coordinate:	-121.3019				
Y Coordinate:	38.67835				
Barrier Area:	Sidewalks				
Barrier Type:	Driveway - Existing (2.1% to 3.0%)				
Code Ref:	CBC 1133B.7.1.3 and ADA/ABA 403.3

As Built Meas:	42	Quantity:	LF		
Description:	Driveway cross slope exceeds 2.0% (2.1% to 3.0%)				
As Built Desc:	2.7% cross slope				
Solution:	Provide min. 48" wide level walkway through driveway				
Bar. Severity:	1 Necessary	Cost Estimate:	\$5,250.00	Status:	
Implementation Priority:	1	Facility Function:			
Implementation Phase:		Implementation Date:			
Official Responsible:

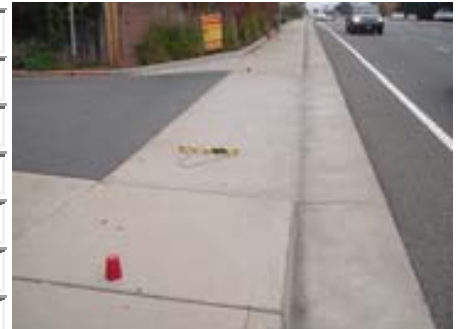
Field Date:	12/3/2010	Report Date:	12/3/2010	Barrier #:	3044
Location:	Greenback Ln - North				
X Coordinate:	-121.30106				
Y Coordinate:	38.67836				
Barrier Area:	Sidewalks				
Barrier Type:	Driveway - Existing (2.1% to 3.0%)				
Code Ref:	CBC 1133B.7.1.3 and ADA/ABA 403.3

As Built Meas:	38	Quantity:	LF		
Description:	Driveway cross slope exceeds 2.0% (2.1% to 3.0%)				
As Built Desc:	2.7% cross slope, 8.6% running slope				
Solution:	Provide min. 48" wide level walkway through driveway				
Bar. Severity:	1 Necessary	Cost Estimate:	\$4,750.00	Status:	
Implementation Priority:	1	Facility Function:			
Implementation Phase:		Implementation Date:			
Official Responsible:

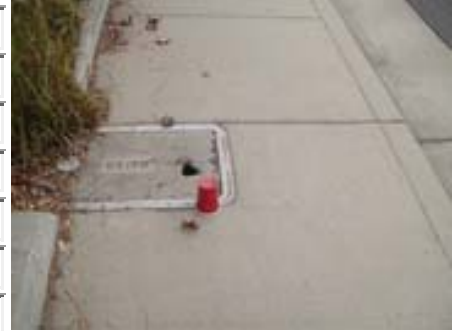
Field Date:	12/3/2010	Report Date:	12/3/2010	Barrier #:	3045
Location:	Greenback Ln - North				
X Coordinate:	-121.30086				
Y Coordinate:	38.67835				
Barrier Area:	Sidewalks				
Barrier Type:	Surface Condition - Damaged				
Code Ref:	CBC 1133B.7.1 and ADA/ABA 302.1

As Built Meas:	4	Quantity:	LF		
Description:	Surface is not firm and stable (cracked, broken or loose soil, etc.)				
As Built Desc:	Cracked concrete				
Solution:	Repair surface to make firm and stable				
Bar. Severity:	1 Necessary	Cost Estimate:	\$500.00	Status:	
Implementation Priority:	1	Facility Function:			
Implementation Phase:		Implementation Date:			
Official Responsible:

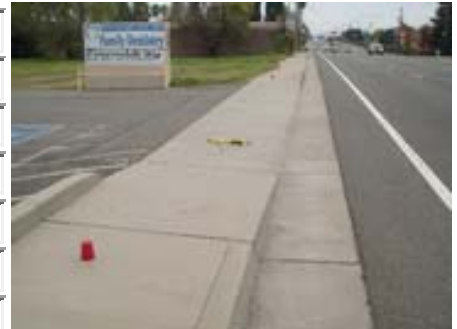
Field Date:	12/3/2010	Report Date:	12/3/2010	Barrier #:	3046
Location:	Greenback Ln - North				
X Coordinate:	-121.30049				
Y Coordinate:	38.67836				
Barrier Area:	Sidewalks				
Barrier Type:	Driveway - Existing (2.1% to 3.0%)				
Code Ref:	CBC 1133B.7.1.3 and ADA/ABA 403.3

As Built Meas:	42	Quantity:	LF		
Description:	Driveway cross slope exceeds 2.0% (2.1% to 3.0%)				
As Built Desc:	3.0% cross slope				
Solution:	Provide min. 48" wide level walkway through driveway				
Bar. Severity:	1 Necessary	Cost Estimate:	\$5,250.00	Status:	
Implementation Priority:	1	Facility Function:			
Implementation Phase:		Implementation Date:			
Official Responsible:

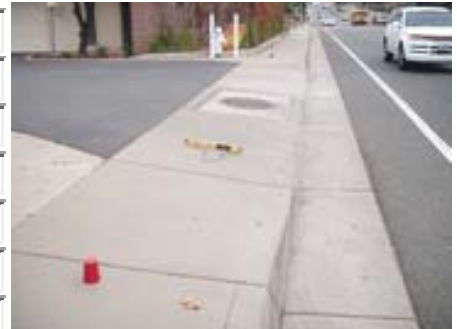
Field Date:	12/3/2010	Report Date:	12/3/2010	Barrier #:	3048
Location:	Greenback Ln - North				
X Coordinate:	-121.2997				
Y Coordinate:	38.67834				
Barrier Area:	Sidewalks				
Barrier Type:	Driveway - Existing (5.0% or more)				
Code Ref:	CBC 1133B.7.1.3 and ADA/ABA 403.3

As Built Meas:	41	Quantity:	LF		
Description:	Driveway cross slope exceeds 2.0% (5.0% or more)				
As Built Desc:	10.4% cross slope				
Solution:	Provide min. 48" wide level walkway through driveway				
Bar. Severity:	4 Low Severity	Cost Estimate:	\$5,125.00	Status:	
Implementation Priority:	1	Facility Function:			
Implementation Phase:		Implementation Date:			
Official Responsible:

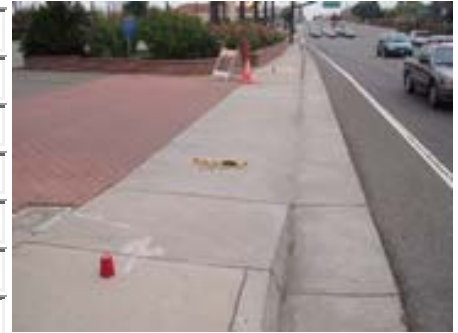
Field Date:	12/3/2010	Report Date:	12/3/2010	Barrier #:	3049
Location:	Greenback Ln - North				
X Coordinate:	-121.29927				
Y Coordinate:	38.67834				
Barrier Area:	Sidewalks				
Barrier Type:	Driveway - Existing (2.1% to 3.0%)				
Code Ref:	CBC 1133B.7.1.3 and ADA/ABA 403.3

As Built Meas:	48	Quantity:	LF		
Description:	Driveway cross slope exceeds 2.0% (2.1% to 3.0%)				
As Built Desc:	3.0% cross slope, 10.0% running slope				
Solution:	Provide min. 48" wide level walkway through driveway				
Bar. Severity:	1 Necessary	Cost Estimate:	\$6,000.00	Status:	
Implementation Priority:	1	Facility Function:			
Implementation Phase:		Implementation Date:			
Official Responsible:

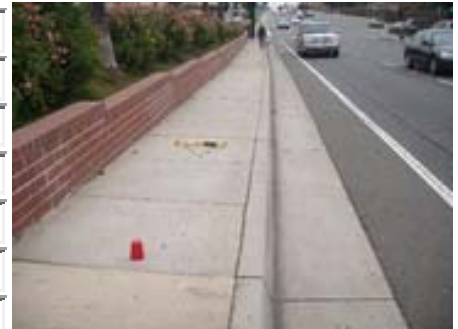
Field Date:	12/3/2010	Report Date:	12/3/2010	Barrier #:	3050
Location:	Greenback Ln - North				
X Coordinate:	-121.29906				
Y Coordinate:	38.67836				
Barrier Area:	Sidewalks				
Barrier Type:	Cross Slope - Existing (4.1% to 4.9%)				
Code Ref:	CBC 1133B.7.1.3 and ADA/ABA 403.3

As Built Meas:	123	Quantity:	LF		
Description:	Cross slope exceeds 2.0% (4.1% to 4.9%)				
As Built Desc:	4.1% cross slope				
Solution:	Demolish existing and construct new route				
Bar. Severity:	2 Recommended	Cost Estimate:	\$15,375.00	Status:	
Implementation Priority:	1	Facility Function:			
Implementation Phase:		Implementation Date:			
Official Responsible:
