**DRAFT ADA TRANSITION PLAN UPDATE  
NEIGHBORHOOD AREA 4 ARCADE CREEK  
SEPTEMBER 20, 2011**

CITY OF CITRUS HEIGHTS

## Arcade Creek Neighborhood Area

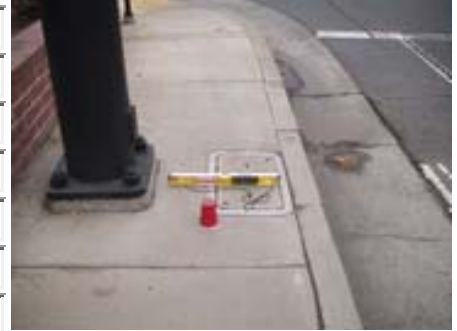
Field Date:	12/3/2010	Report Date:	12/3/2010	Barrier #:	3051
Location:	Greenback Ln - North				
X Coordinate:	-121.29856				
Y Coordinate:	38.67837				
Barrier Area:	Sidewalks				
Barrier Type:	Clear Width - Existing ( $\leq 31"$ or less)				
Code Ref:	CBC 1133B.7.1

As Built Meas:	4	Quantity:	LF		
Description:	Pedestrian route is not min. 48" wide ( $\leq 31"$ or less)				
As Built Desc:	26" clear width due to pole				
Solution:	Demolish existing and construct new route				
Bar. Severity:	1 Necessary	Cost Estimate:	\$500.00	Status:	
Implementation Priority:	1	Facility Function:			
Implementation Phase:		Implementation Date:			
Official Responsible:

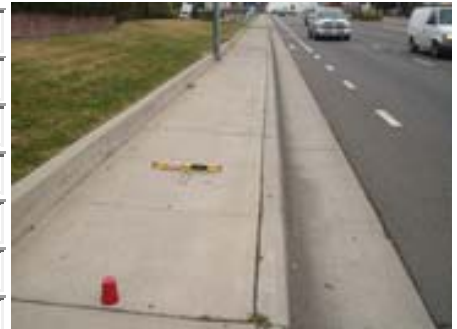
Field Date:	12/3/2010	Report Date:	12/3/2010	Barrier #:	3052
Location:	Greenback Ln - North				
X Coordinate:	-121.29807				
Y Coordinate:	38.67838				
Barrier Area:	Sidewalks				
Barrier Type:	Cross Slope - Existing (4.1% to 4.9%)				
Code Ref:	CBC 1133B.7.1.3 and ADA/ABA 403.3

As Built Meas:	117	Quantity:	LF		
Description:	Cross slope exceeds 2.0% (4.1% to 4.9%)				
As Built Desc:	4.3% cross slope				
Solution:	Demolish existing and construct new route				
Bar. Severity:	2 Recommended	Cost Estimate:	\$14,625.00	Status:	
Implementation Priority:	1	Facility Function:			
Implementation Phase:		Implementation Date:			
Official Responsible:

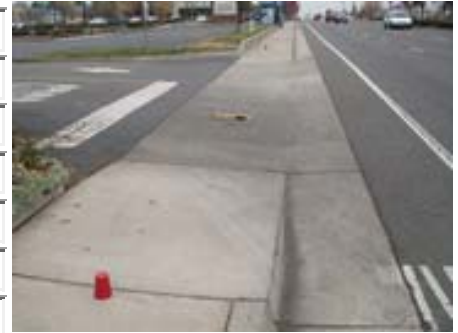
Field Date:	12/3/2010	Report Date:	12/3/2010	Barrier #:	3053
Location:	Greenback Ln - North				
X Coordinate:	-121.29762				
Y Coordinate:	38.67835				
Barrier Area:	Sidewalks				
Barrier Type:	Driveway - Existing (5.0% or more)				
Code Ref:	CBC 1133B.7.1.3 and ADA/ABA 403.3

As Built Meas:	46	Quantity:	LF		
Description:	Driveway cross slope exceeds 2.0% (5.0% or more)				
As Built Desc:	5.9% cross slope				
Solution:	Provide min. 48" wide level walkway through driveway				
Bar. Severity:	4 Low Severity	Cost Estimate:	\$5,750.00	Status:	
Implementation Priority:	1	Facility Function:			
Implementation Phase:		Implementation Date:			
Official Responsible:

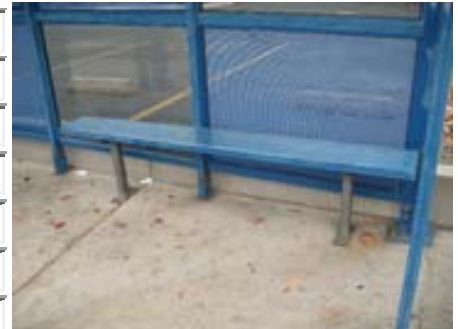
Field Date:	12/3/2010	Report Date:	12/3/2010	Barrier #:	3054A
Location:	Greenback Ln - North				
X Coordinate:	-121.29708				
Y Coordinate:	38.67841				
Barrier Area:	Bus Stops and Shelters				
Barrier Type:	Bench Seat Depth				
Code Ref:	ADAAG 4.37.1 and ADA/ABA 903.4

As Built Meas:	1	Quantity:	EACH		
Description:	Bench seat depth not 20" - 24" deep				
As Built Desc:	9-1/2" bench seat depth				
Solution:	Provide min. 1 accessible bench at bench stop				
Bar. Severity:	3 Hindrance	Cost Estimate:	\$775.00	Status:	
Implementation Priority:	1	Facility Function:			
Implementation Phase:		Implementation Date:			
Official Responsible:

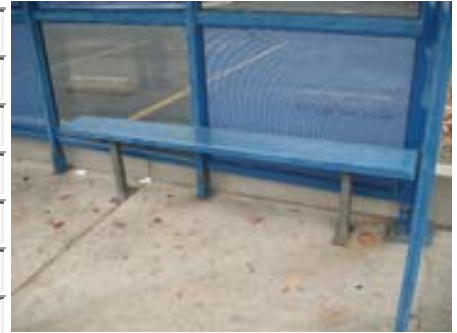
Field Date:	12/3/2010	Report Date:	12/3/2010	Barrier #:	3054B
Location:	Greenback Ln - North				
X Coordinate:	-121.29708				
Y Coordinate:	38.67841				
Barrier Area:	Bus Stops and Shelters				
Barrier Type:	Bench Back Support				
Code Ref:	ADAAG 4.37.4 and ADA/ABA 903.4

As Built Meas:	1	Quantity:	EACH		
Description:	Bench has no back support of at least 18" high				
As Built Desc:	No back support provided				
Solution:	Provide min. 1 accessible bench at bench stop or shelter				
Bar. Severity:	3 Hindrance	Cost Estimate:	\$0.00	Status:	
Implementation Priority:	1	Facility Function:			
Implementation Phase:		Implementation Date:			
Official Responsible:

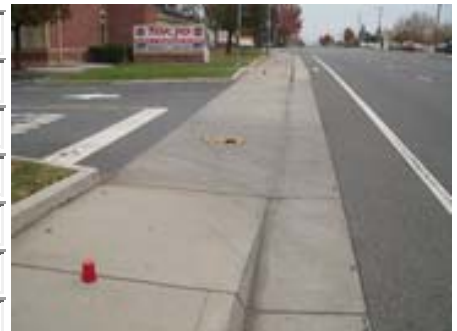
Field Date:	12/3/2010	Report Date:	12/3/2010	Barrier #:	3055
Location:	Greenback Ln - North				
X Coordinate:	-121.29665				
Y Coordinate:	38.67839				
Barrier Area:	Sidewalks				
Barrier Type:	Driveway - Existing (4.1% to 4.9%)				
Code Ref:	CBC 1133B.7.1.3 and ADA/ABA 403.3

As Built Meas:	52	Quantity:	LF		
Description:	Driveway cross slope exceeds 2.0% (4.1% to 4.9%)				
As Built Desc:	4.6% cross slope				
Solution:	Provide min. 48" wide level walkway through driveway				
Bar. Severity:	3 Hinderance	Cost Estimate:	\$6,500.00	Status:	
Implementation Priority:	1	Facility Function:			
Implementation Phase:		Implementation Date:			
Official Responsible:

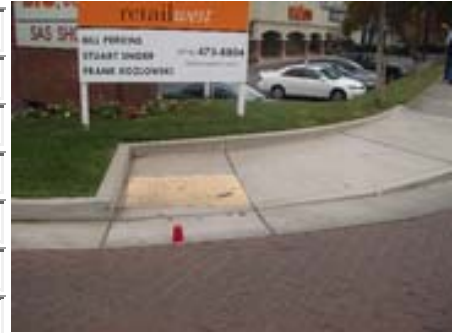
Barrier Type: Gutter Slope - Existing (8.3% or more)

As Built Meas: 6 Quantity: SF

Description: Gutter slope exceeds 5.0% (8.3% or more)

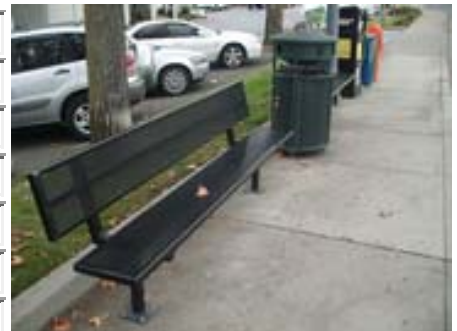
Barrier Type: Bench Seat Depth

As Built Meas: 1 Quantity: EACH

Description: Bench seat depth not 20" - 24" deep

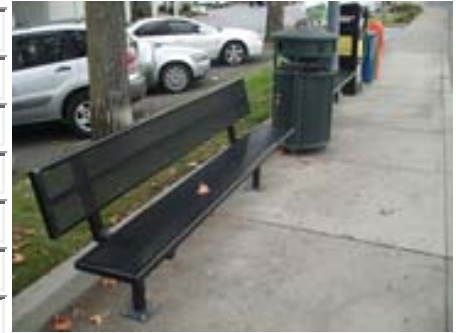
Field Date:	12/3/2010	Report Date:	12/3/2010	Barrier #:	3057B
Location:	Greenback Ln - North				
X Coordinate:	-121.29321				
Y Coordinate:	38.67843				
Barrier Area:	Bus Stops and Shelters				
Barrier Type:	Bench Seat Height				
Code Ref:	ADAAG 4.37.3* and ADA/ABA 903.4

As Built Meas:	1	Quantity:	EACH	
Description:	Bench seat height not between 17" - 19"			
As Built Desc:	16" bench seat height			
Solution:	Provide new compliant bench or remount at compliant height where possible			
Bar. Severity:	3 Hindrance	Cost Estimate:	\$0.00	Status:
Implementation Priority:	1	Facility Function:		
Implementation Phase:		Implementation Date:		
Official Responsible:

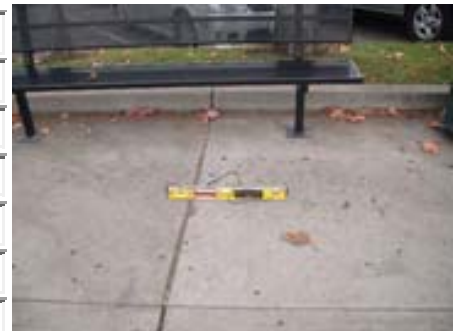
Field Date:	12/3/2010	Report Date:	12/3/2010	Barrier #:	3057C
Location:	Greenback Ln - North				
X Coordinate:	-121.29321				
Y Coordinate:	38.67843				
Barrier Area:	Bus Stops and Shelters				
Barrier Type:	Cross Slope - Existing (5.0% or more)				
Code Ref:	CBC 1121B.2.1 and ADAAG 10.2.1(1)

As Built Meas:	8	Quantity:	LF	
Description:	Cross slope at bus pad or shelter exceeds 2.0% (5.0% or more)			
As Built Desc:	12.6% cross slope			
Solution:	Demolish existing and construct new bus pad or shelter pad			
Bar. Severity:	1 Necessary	Cost Estimate:	\$1,000.00	Status:
Implementation Priority:	1	Facility Function:		
Implementation Phase:		Implementation Date:		
Official Responsible:

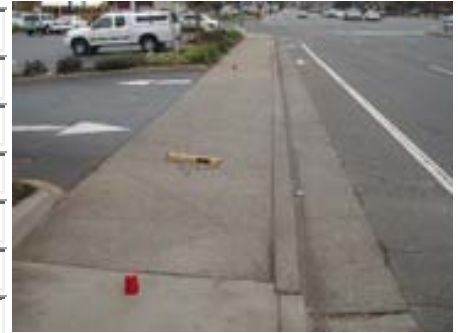
Field Date:	12/3/2010	Report Date:	12/3/2010	Barrier #:	3058
Location:	Greenback Ln - North				
X Coordinate:	-121.29308				
Y Coordinate:	38.67844				
Barrier Area:	Sidewalks				
Barrier Type:	Driveway - Existing (5.0% or more)				
Code Ref:	CBC 1133B.7.1.3 and ADA/ABA 403.3

As Built Meas:	39	Quantity:	LF		
Description:	Driveway cross slope exceeds 2.0% (5.0% or more)				
As Built Desc:	6.8% cross slope, 13.4% running slope				
Solution:	Provide min. 48" wide level walkway through driveway				
Bar. Severity:	1 Necessary	Cost Estimate:	\$4,875.00	Status:	
Implementation Priority:	1	Facility Function:			
Implementation Phase:		Implementation Date:			
Official Responsible:

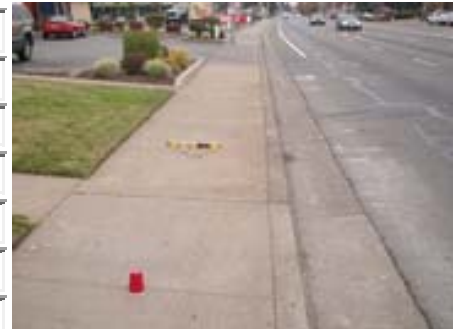
Field Date:	12/3/2010	Report Date:	12/3/2010	Barrier #:	3059
Location:	Greenback Ln - North				
X Coordinate:	-121.29209				
Y Coordinate:	38.67846				
Barrier Area:	Sidewalks				
Barrier Type:	Cross Slope - Existing (4.1% to 4.9%)				
Code Ref:	CBC 1133B.7.1.3 and ADA/ABA 403.3

As Built Meas:	45	Quantity:	LF		
Description:	Cross slope exceeds 2.0% (4.1% to 4.9%)				
As Built Desc:	4.6% cross slope				
Solution:	Demolish existing and construct new route				
Bar. Severity:	2 Recommended	Cost Estimate:	\$5,625.00	Status:	
Implementation Priority:	1	Facility Function:			
Implementation Phase:		Implementation Date:			
Official Responsible:

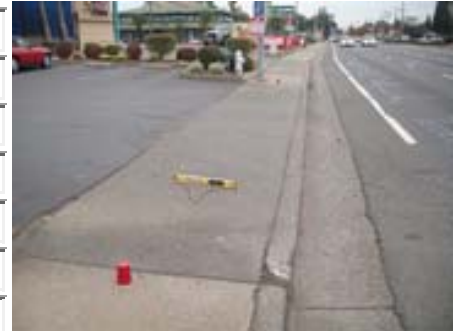
Field Date:	12/3/2010	Report Date:	12/3/2010	Barrier #:	3060
Location:	Greenback Ln - North				
X Coordinate:	-121.29192				
Y Coordinate:	38.67847				
Barrier Area:	Sidewalks				
Barrier Type:	Driveway - Existing (5.0% or more)				
Code Ref:	CBC 1133B.7.1.3 and ADA/ABA 403.3

As Built Meas:	39	Quantity:	LF	
Description:	Driveway cross slope exceeds 2.0% (5.0% or more)			
As Built Desc:	8.8% cross slope, 9.4% running slope			
Solution:	Provide min. 48" wide level walkway through driveway			
Bar. Severity:	1 Necessary	Cost Estimate:	\$4,875.00	Status:
Implementation Priority:	1	Facility Function:		
Implementation Phase:		Implementation Date:		
Official Responsible:

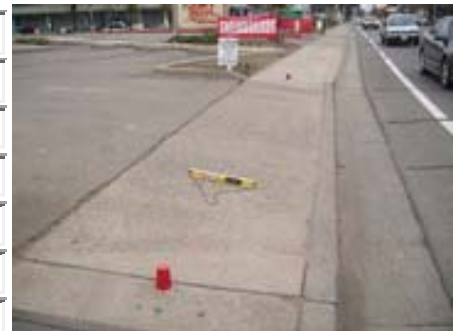
Field Date:	12/3/2010	Report Date:	12/3/2010	Barrier #:	3061
Location:	Greenback Ln - North				
X Coordinate:	-121.29171				
Y Coordinate:	38.67845				
Barrier Area:	Sidewalks				
Barrier Type:	Driveway - Existing (5.0% or more)				
Code Ref:	CBC 1133B.7.1.3 and ADA/ABA 403.3

As Built Meas:	28	Quantity:	LF	
Description:	Driveway cross slope exceeds 2.0% (5.0% or more)			
As Built Desc:	10.2% cross slope, 12.6% running slope			
Solution:	Provide min. 48" wide level walkway through driveway			
Bar. Severity:	1 Necessary	Cost Estimate:	\$3,500.00	Status:
Implementation Priority:	1	Facility Function:		
Implementation Phase:		Implementation Date:		
Official Responsible:

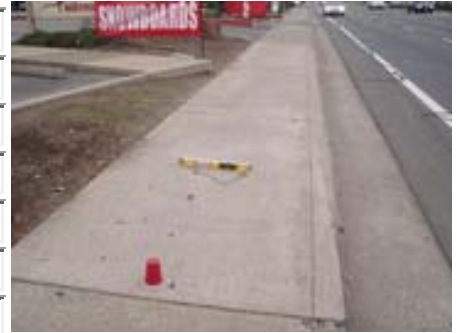
Field Date:	12/3/2010	Report Date:	12/3/2010	Barrier #:	3062
Location:	Greenback Ln - North				
X Coordinate:	-121.29162				
Y Coordinate:	38.67845				
Barrier Area:	Sidewalks				
Barrier Type:	Driveway - Existing (4.1% to 4.9%)				
Code Ref:	CBC 1133B.7.1.3 and ADA/ABA 403.3

As Built Meas:	20	Quantity:	LF		
Description:	Driveway cross slope exceeds 2.0% (4.1% to 4.9%)				
As Built Desc:	4.3% cross slope				
Solution:	Provide min. 48" wide level walkway through driveway				
Bar. Severity:	3 Hinderance	Cost Estimate:	\$2,500.00	Status:	
Implementation Priority:	1	Facility Function:			
Implementation Phase:		Implementation Date:			
Official Responsible:

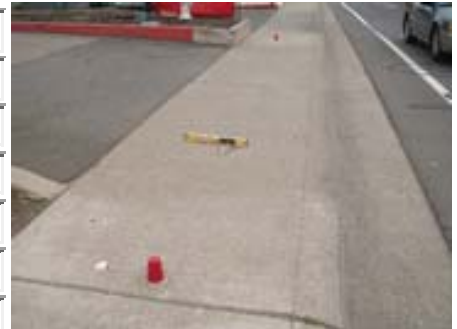
Field Date:	12/3/2010	Report Date:	12/3/2010	Barrier #:	3063
Location:	Greenback Ln - North				
X Coordinate:	-121.2914				
Y Coordinate:	38.67845				
Barrier Area:	Sidewalks				
Barrier Type:	Driveway - Existing (5.0% or more)				
Code Ref:	CBC 1133B.7.1.3 and ADA/ABA 403.3

As Built Meas:	34	Quantity:	LF		
Description:	Driveway cross slope exceeds 2.0% (5.0% or more)				
As Built Desc:	5.6% cross slope				
Solution:	Provide min. 48" wide level walkway through driveway				
Bar. Severity:	4 Low Severity	Cost Estimate:	\$4,250.00	Status:	
Implementation Priority:	1	Facility Function:			
Implementation Phase:		Implementation Date:			
Official Responsible:

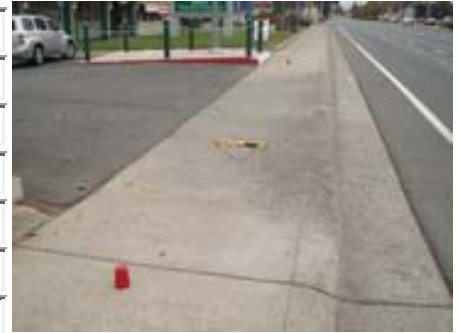
Field Date:	12/3/2010	Report Date:	12/3/2010	Barrier #:	3064
Location:	Greenback Ln - North				
X Coordinate:	-121.29131				
Y Coordinate:	38.67846				
Barrier Area:	Sidewalks				
Barrier Type:	Driveway - Existing (2.1% to 3.0%)				
Code Ref:	CBC 1133B.7.1.3 and ADA/ABA 403.3

As Built Meas:	40	Quantity:	LF		
Description:	Driveway cross slope exceeds 2.0% (2.1% to 3.0%)				
As Built Desc:	2.8% cross slope, 8.9% running slope				
Solution:	Provide min. 48" wide level walkway through driveway				
Bar. Severity:	1 Necessary	Cost Estimate:	\$5,000.00	Status:	
Implementation Priority:	1	Facility Function:			
Implementation Phase:		Implementation Date:			
Official Responsible:

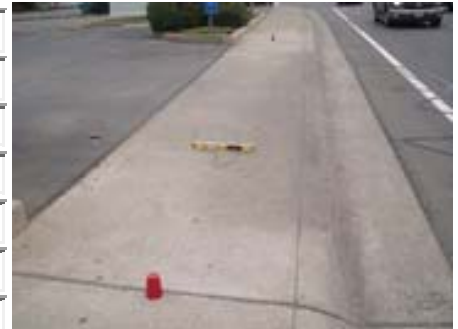
Field Date:	12/3/2010	Report Date:	12/3/2010	Barrier #:	3065
Location:	Greenback Ln - North				
X Coordinate:	-121.29084				
Y Coordinate:	38.67845				
Barrier Area:	Sidewalks				
Barrier Type:	Driveway - Existing (4.1% to 4.9%)				
Code Ref:	CBC 1133B.7.1.3 and ADA/ABA 403.3

As Built Meas:	36	Quantity:	LF		
Description:	Driveway cross slope exceeds 2.0% (4.1% to 4.9%)				
As Built Desc:	4.7% cross slope				
Solution:	Provide min. 48" wide level walkway through driveway				
Bar. Severity:	3 Hinderance	Cost Estimate:	\$4,500.00	Status:	
Implementation Priority:	1	Facility Function:			
Implementation Phase:		Implementation Date:			
Official Responsible:

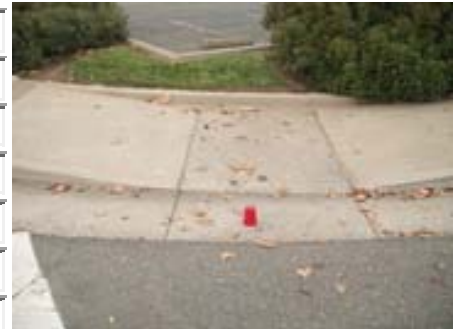
Field Date:	12/3/2010	Report Date:	12/3/2010	Barrier #:	3067E
Location:	Greenback Ln and Sylvan Wy - Corner A				
X Coordinate:	-121.29038				
Y Coordinate:	38.67846				
Barrier Area:	Curb Ramps				
Barrier Type:	Gutter Slope - Existing (5.9% - 6.5%)				
Code Ref:	CBC 1127B.5.3 and ADA/ABA 406.2

As Built Meas:	6	Quantity:	SF		
Description:	Gutter slope exceeds 5.0% (5.9% - 6.5%)				
As Built Desc:	5.9% gutter slope				
Solution:	Demolish existing and construct new gutter				
Bar. Severity:	3 Hindrance	Cost Estimate:	\$0.00	Status:	
Implementation Priority:	1	Facility Function:			
Implementation Phase:		Implementation Date:			
Official Responsible:

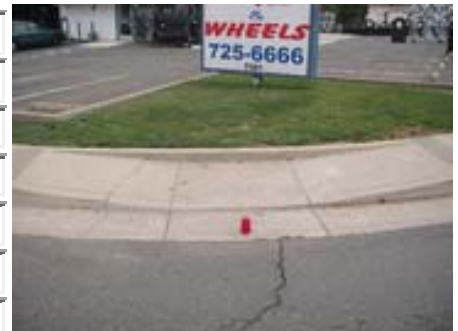
Field Date:	12/3/2010	Report Date:	12/3/2010	Barrier #:	3068A
Location:	Greenback Ln and Sylvan Wy - Corner B				
X Coordinate:	-121.29016				
Y Coordinate:	38.67843				
Barrier Area:	Curb Ramps				
Barrier Type:	12" Grooves - Existing (3.1% to 4.0%)				
Code Ref:	CBC 1127B.5.6

As Built Meas:	1	Quantity:	EACH		
Description:	12" grooves at top of curb ramp are not level (3.1% to 4.0%)				
As Built Desc:	3.9% at 12" grooves				
Solution:	Demolish existing and construct new curb ramp				
Bar. Severity:	3 Hindrance	Cost Estimate:	\$2,500.00	Status:	
Implementation Priority:	1	Facility Function:			
Implementation Phase:		Implementation Date:			
Official Responsible:

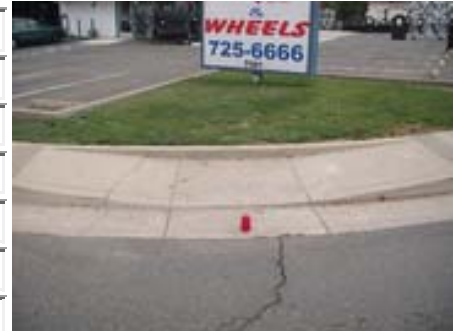
Field Date:	12/3/2010	Report Date:	12/3/2010	Barrier #:	3068D
Location:	Greenback Ln and Sylvan Wy - Corner B				
X Coordinate:	-121.29016				
Y Coordinate:	38.67843				
Barrier Area:	Curb Ramps				
Barrier Type:	Detectable Warnings - Truncated Domes				
Code Ref:	CBC 1127B.5.7 and ADA/ABA 705.1.3

As Built Meas:	1	Quantity:	EACH		
Description:	No truncated domes provided at curb ramp				
As Built Desc:	No detectable warnings at curb ramp				
Solution:	Provide compliant truncated domes				
Bar. Severity:	2 Recommended	Cost Estimate:	\$0.00	Status:	
Implementation Priority:	1	Facility Function:			
Implementation Phase:		Implementation Date:			
Official Responsible:

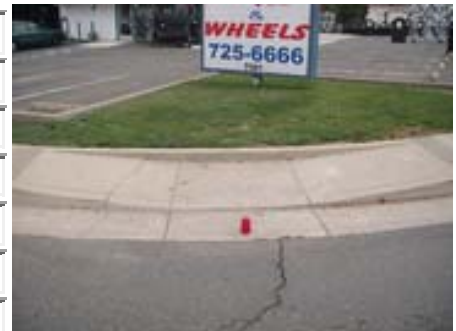
Field Date:	12/3/2010	Report Date:	12/3/2010	Barrier #:	3068E
Location:	Greenback Ln and Sylvan Wy - Corner B				
X Coordinate:	-121.29016				
Y Coordinate:	38.67843				
Barrier Area:	Curb Ramps				
Barrier Type:	Lip - Bottom of Ramp at Flow Line				
Code Ref:	CBC 1127B.5.3 and ADA/ABA 303.3

As Built Meas:	1	Quantity:	EACH		
Description:	Transition at ramp bottom (flow line) is not flush and free of any lip				
As Built Desc:	1" lip at flow line				
Solution:	Remove lip to create flush transition				
Bar. Severity:	1 Necessary	Cost Estimate:	\$0.00	Status:	
Implementation Priority:	1	Facility Function:			
Implementation Phase:		Implementation Date:			
Official Responsible:

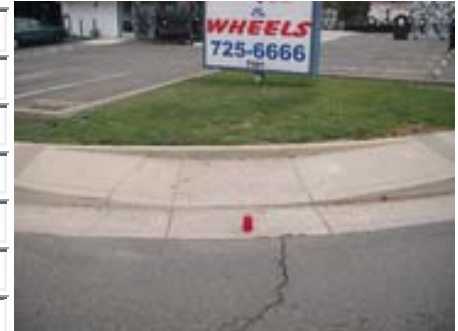
Field Date:	12/3/2010	Report Date:	12/3/2010	Barrier #:	3068F
Location:	Greenback Ln and Sylvan Wy - Corner B				
X Coordinate:	-121.29016				
Y Coordinate:	38.67843				
Barrier Area:	Curb Ramps				
Barrier Type:	Gutter Slope - Existing (8.3% or more)				
Code Ref:	CBC 1127B.5.3 and ADA/ABA 406.2

As Built Meas:	6	Quantity:	SF
Description:	Gutter slope exceeds 5.0% (8.3% or more)		
As Built Desc:	9.0% gutter slope		
Solution:	Demolish existing and construct new gutter		
Bar. Severity:	1 Necessary	Cost Estimate:	\$0.00
Implementation Priority:	1	Facility Function:	
Implementation Phase:		Implementation Date:	
Official Responsible:

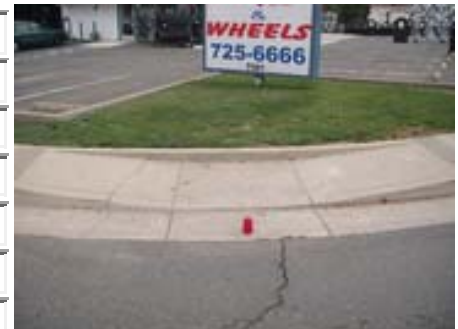
Field Date:	12/3/2010	Report Date:	12/3/2010	Barrier #:	3068G
Location:	Greenback Ln and Sylvan Wy - Corner B				
X Coordinate:	-121.29016				
Y Coordinate:	38.67843				
Barrier Area:	Curb Ramps				
Barrier Type:	Lip - Gutter to Asphalt Transition				
Code Ref:	CBC 1127B.5.3 and ADA/ABA 303.3

As Built Meas:	1	Quantity:	EACH
Description:	Transition at transition into asphalt not flush and free of any lip		
As Built Desc:	1/2" lip at asphalt transition into roadway		
Solution:	Remove lip to create flush transition		
Bar. Severity:	1 Necessary	Cost Estimate:	\$0.00
Implementation Priority:	1	Facility Function:	
Implementation Phase:		Implementation Date:	
Official Responsible:

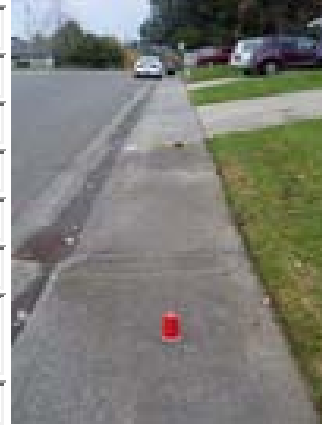
Field Date:	12/2/2010	Report Date:	12/3/2010	Barrier #:	3069
Location:	Mercedes Ave - South				
X Coordinate:	-121.31034				
Y Coordinate:	38.6803				
Barrier Area:	Sidewalks				
Barrier Type:	Cross Slope - Existing (5.0% or more)				
Code Ref:	CBC 1133B.7.1.3 and ADA/ABA 403.3

As Built Meas:	353	Quantity:	LF	
Description:	Cross slope exceeds 2.0% (5.0% or more)			
As Built Desc:	5.3% cross slope			
Solution:	Demolish existing and construct new route			
Bar. Severity:	1 Necessary	Cost Estimate:	\$44,125.00	Status:
Implementation Priority:	3	Facility Function:		
Implementation Phase:		Implementation Date:		
Official Responsible:

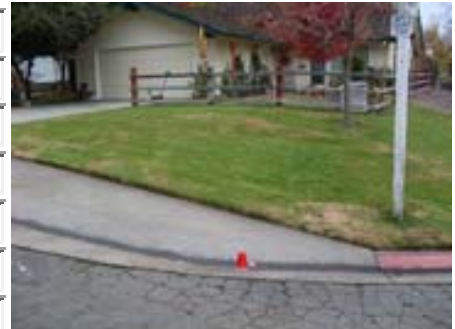
Field Date:	12/2/2010	Report Date:	12/3/2010	Barrier #:	3070
Location:	Mercedes Ave and Chapel View Ln - Corner A				
X Coordinate:	-121.30893				
Y Coordinate:	38.68037				
Barrier Area:	Curb Ramps				
Barrier Type:	No Curb Ramp				
Code Ref:	CBC 1127B.5.1 and ADA/ABA 402.2

As Built Meas:	1	Quantity:	EACH	
Description:	No curb cut at corner (intersection)			
As Built Desc:	No curb ramp at corner			
Solution:	Demolish existing and construct curb cut			
Bar. Severity:	1 Necessary	Cost Estimate:	\$2,500.00	Status:
Implementation Priority:	3	Facility Function:		
Implementation Phase:		Implementation Date:		
Official Responsible:

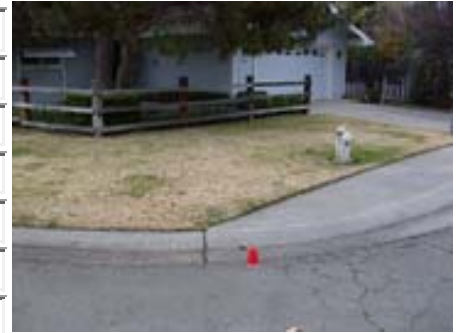
Field Date:	12/2/2010	Report Date:	12/3/2010	Barrier #:	3071
Location:	Mercedes Ave and Chapel View Ln - Corner B				
X Coordinate:	-121.3088				
Y Coordinate:	38.6804				
Barrier Area:	Curb Ramps				
Barrier Type:	No Curb Ramp				
Code Ref:	CBC 1127B.5.1 and ADA/ABA 402.2

As Built Meas:	1	Quantity:	EACH
Description:	No curb cut at corner (intersection)		
As Built Desc:	No curb ramp at corner		
Solution:	Demolish existing and construct curb cut		
Bar. Severity:	1 Necessary	Cost Estimate:	\$2,500.00
Implementation Priority:	3	Facility Function:	
Implementation Phase:		Implementation Date:	
Official Responsible:

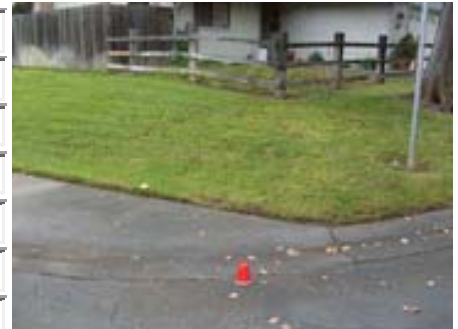
Field Date:	12/2/2010	Report Date:	12/3/2010	Barrier #:	3072
Location:	Mercedes Ave and Chapel View Ln - Corner C				
X Coordinate:	-121.30879				
Y Coordinate:	38.68028				
Barrier Area:	Curb Ramps				
Barrier Type:	No Curb Ramp				
Code Ref:	CBC 1127B.5.1 and ADA/ABA 402.2

As Built Meas:	1	Quantity:	EACH
Description:	No curb cut at corner (intersection)		
As Built Desc:	No curb ramp at corner		
Solution:	Demolish existing and construct curb cut		
Bar. Severity:	1 Necessary	Cost Estimate:	\$2,500.00
Implementation Priority:	3	Facility Function:	
Implementation Phase:		Implementation Date:	
Official Responsible:

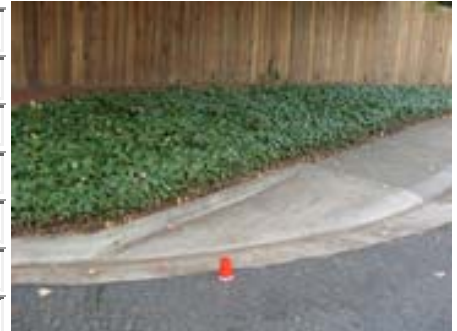
Field Date:	12/2/2010	Report Date:	12/3/2010	Barrier #:	3073A
Location:	Mercedes Ave and Chapel View Ln - Corner D				
X Coordinate:	-121.30893				
Y Coordinate:	38.68028				
Barrier Area:	Curb Ramps				
Barrier Type:	12" Grooves - Existing (3.1% to 4.0%)				
Code Ref:	CBC 1127B.5.6

As Built Meas:	1	Quantity:	EACH		
Description:	12" grooves at top of curb ramp are not level (3.1% to 4.0%)				
As Built Desc:	3.7% at 12" grooves				
Solution:	Demolish existing and construct new curb ramp				
Bar. Severity:	3 Hindrance	Cost Estimate:	\$2,500.00	Status:	
Implementation Priority:	3	Facility Function:			
Implementation Phase:		Implementation Date:			
Official Responsible:

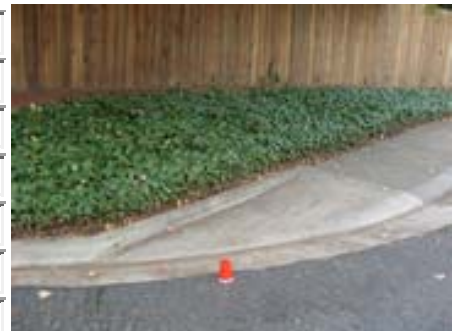
As Built Meas:	1	Quantity:	EACH		
Description:	No truncated domes provided at curb ramp				
As Built Desc:	No detectable warnings at curb ramp				
Solution:	Provide compliant truncated domes				
Bar. Severity:	2 Recommended	Cost Estimate:	\$0.00	Status:	
Implementation Priority:	3	Facility Function:			
Implementation Phase:		Implementation Date:			
Official Responsible:

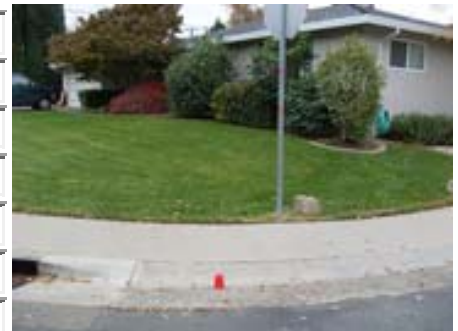
Field Date:	12/2/2010	Report Date:	12/3/2010	Barrier #:	3075
Location:	Mercedes Ave and Paris St - Corner C				
X Coordinate:	-121.30788				
Y Coordinate:	38.68032				
Barrier Area:	Curb Ramps				
Barrier Type:	No Curb Ramp				
Code Ref:	CBC 1127B.5.1 and ADA/ABA 402.2

As Built Meas:	1	Quantity:	EACH	
Description:	No curb cut at corner (intersection)			
As Built Desc:	No curb ramp at corner			
Solution:	Demolish existing and construct curb cut			
Bar. Severity:	1 Necessary	Cost Estimate:	\$2,500.00	Status:
Implementation Priority:	3	Facility Function:		
Implementation Phase:		Implementation Date:		
Official Responsible:

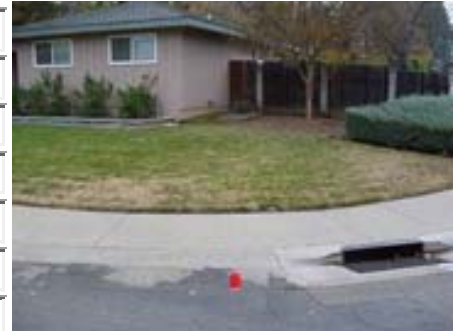
Field Date:	12/2/2010	Report Date:	12/3/2010	Barrier #:	3076
Location:	Mercedes Ave and Paris St - Corner D				
X Coordinate:	-121.30802				
Y Coordinate:	38.68032				
Barrier Area:	Curb Ramps				
Barrier Type:	No Curb Ramp				
Code Ref:	CBC 1127B.5.1 and ADA/ABA 402.2

As Built Meas:	1	Quantity:	EACH	
Description:	No curb cut at corner (intersection)			
As Built Desc:	No curb ramp at corner			
Solution:	Demolish existing and construct curb cut			
Bar. Severity:	1 Necessary	Cost Estimate:	\$2,500.00	Status:
Implementation Priority:	3	Facility Function:		
Implementation Phase:		Implementation Date:		
Official Responsible:

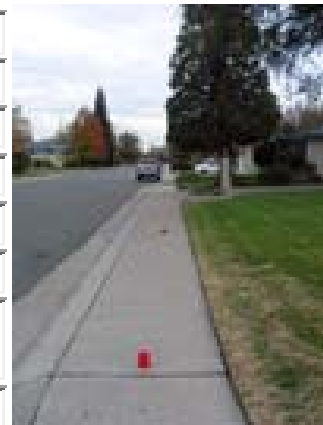
Field Date:	12/2/2010	Report Date:	12/3/2010	Barrier #:	3077A
Location:	Paris St - West				
X Coordinate:	-121.30801				
Y Coordinate:	38.68011				
Barrier Area:	Sidewalks				
Barrier Type:	Cross Slope - Existing (5.0% or more)				
Code Ref:	CBC 1133B.7.1.3 and ADA/ABA 403.3

As Built Meas:	670	Quantity:	LF	
Description:	Cross slope exceeds 2.0% (5.0% or more)			
As Built Desc:	5.1% cross slope			
Solution:	Demolish existing and construct new route			
Bar. Severity:	1 Necessary	Cost Estimate:	\$83,750.00	Status:
Implementation Priority:	4	Facility Function:		
Implementation Phase:		Implementation Date:		
Official Responsible:

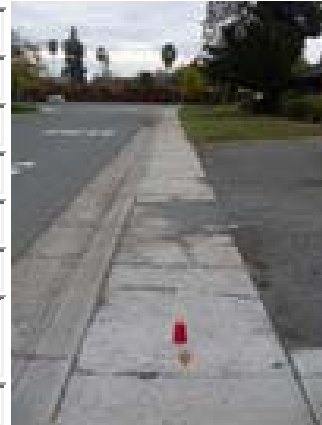
Barrier Type: Surface Condition - Damaged

Description: Surface is not firm and stable (cracked, broken or loose soil, etc.)

As Built Desc: Cracked concrete and loose gravel

Solution: Repair surface to make firm and stable

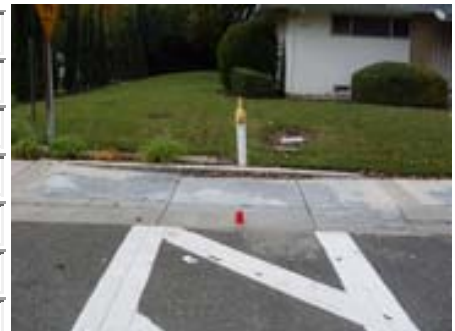
Barrier Type: 12" Grooves - Existing (3.1% to 4.0%)

Description: 12" grooves at top of curb ramp are not level (3.1% to 4.0%)

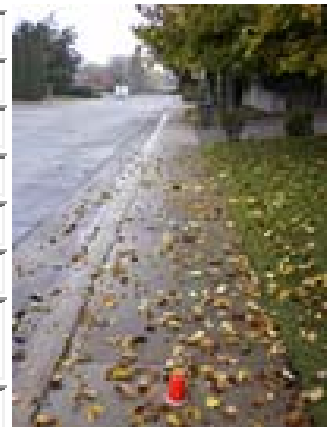
Field Date:	12/2/2010	Report Date:	12/3/2010	Barrier #:	3080A
Location:	Paris St - East				
X Coordinate:	-121.30785				
Y Coordinate:	38.67852				
Barrier Area:	Sidewalks				
Barrier Type:	Cross Slope - Existing (3.1% to 4.0%)				
Code Ref:	CBC 1133B.7.1.3 and ADA/ABA 403.3

As Built Meas:	153	Quantity:	LF	
Description:	Cross slope exceeds 2.0% (3.1% to 4.0%)			
As Built Desc:	3.8% cross slope			
Solution:	Demolish existing and construct new route			
Bar. Severity:	3 Hinderance	Cost Estimate:	\$19,125.00	Status:
Implementation Priority:	4	Facility Function:		
Implementation Phase:		Implementation Date:		
Official Responsible:

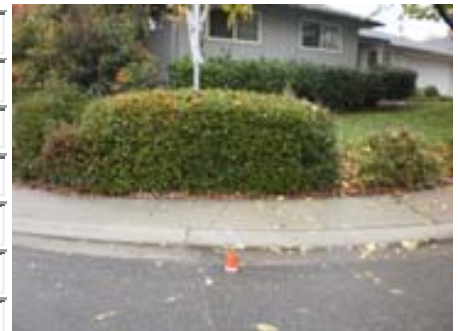
Field Date:	12/2/2010	Report Date:	12/3/2010	Barrier #:	3081
Location:	Paris St and Le Mans Ave - Corner B				
X Coordinate:	-121.30786				
Y Coordinate:	38.679				
Barrier Area:	Curb Ramps				
Barrier Type:	No Curb Ramp				
Code Ref:	CBC 1127B.5.1 and ADA/ABA 402.2

As Built Meas:	1	Quantity:	EACH	
Description:	No curb cut at corner (intersection)			
As Built Desc:	No curb ramp at corner			
Solution:	Demolish existing and construct curb cut			
Bar. Severity:	1 Necessary	Cost Estimate:	\$2,500.00	Status:
Implementation Priority:	4	Facility Function:		
Implementation Phase:		Implementation Date:		
Official Responsible:

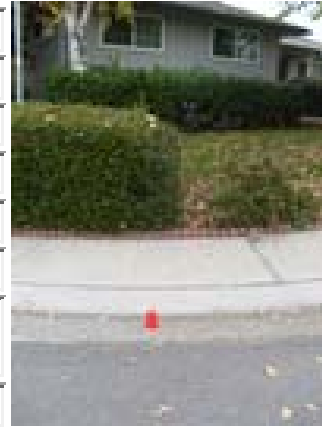
Field Date:	12/2/2010	Report Date:	12/3/2010	Barrier #:	3082
Location:	Paris St and Le Mans Ave - Corner C				
X Coordinate:	-121.30786				
Y Coordinate:	38.67893				
Barrier Area:	Curb Ramps				
Barrier Type:	No Curb Ramp				
Code Ref:	CBC 1127B.5.1 and ADA/ABA 402.2

As Built Meas:	1	Quantity:	EACH	
Description:	No curb cut at corner (intersection)			
As Built Desc:	No curb ramp at corner			
Solution:	Demolish existing and construct curb cut			
Bar. Severity:	1 Necessary	Cost Estimate:	\$2,500.00	Status:
Implementation Priority:	4	Facility Function:		
Implementation Phase:		Implementation Date:		
Official Responsible:

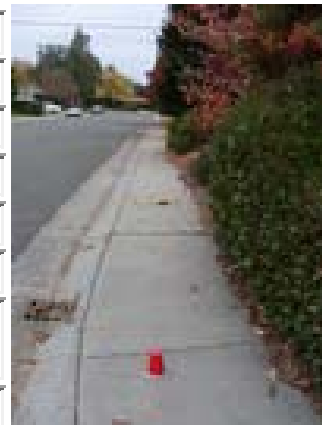
Field Date:	12/2/2010	Report Date:	12/3/2010	Barrier #:	3083
Location:	Paris St - East				
X Coordinate:	-121.30786				
Y Coordinate:	38.67937				
Barrier Area:	Sidewalks				
Barrier Type:	Cross Slope - Existing (4.1% to 4.9%)				
Code Ref:	CBC 1133B.7.1.3 and ADA/ABA 403.3

As Built Meas:	192	Quantity:	LF	
Description:	Cross slope exceeds 2.0% (4.1% to 4.9%)			
As Built Desc:	4.6% cross slope			
Solution:	Demolish existing and construct new route			
Bar. Severity:	2 Recommended	Cost Estimate:	\$24,000.00	Status:
Implementation Priority:	4	Facility Function:		
Implementation Phase:		Implementation Date:		
Official Responsible:

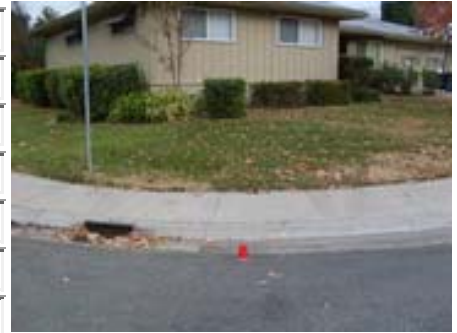
Field Date:	12/2/2010	Report Date:	12/3/2010	Barrier #:	3084
Location:	Paris St and Shalimar Wy - Corner B				
X Coordinate:	-121.30786				
Y Coordinate:	38.67976				
Barrier Area:	Curb Ramps				
Barrier Type:	No Curb Ramp				
Code Ref:	CBC 1127B.5.1 and ADA/ABA 402.2

As Built Meas:	1	Quantity:	EACH		
Description:	No curb cut at corner (intersection)				
As Built Desc:	No curb ramp at corner				
Solution:	Demolish existing and construct curb cut				
Bar. Severity:	1 Necessary	Cost Estimate:	\$2,500.00	Status:	
Implementation Priority:	4	Facility Function:			
Implementation Phase:		Implementation Date:			
Official Responsible:

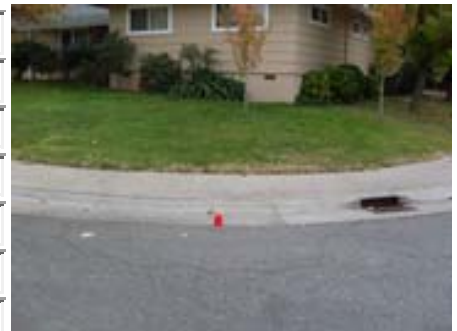
Field Date:	12/2/2010	Report Date:	12/3/2010	Barrier #:	3085
Location:	Paris St and Shalimar Wy - Corner C				
X Coordinate:	-121.30788				
Y Coordinate:	38.67963				
Barrier Area:	Curb Ramps				
Barrier Type:	No Curb Ramp				
Code Ref:	CBC 1127B.5.1 and ADA/ABA 402.2

As Built Meas:	1	Quantity:	EACH		
Description:	No curb cut at corner (intersection)				
As Built Desc:	No curb ramp at corner				
Solution:	Demolish existing and construct curb cut				
Bar. Severity:	1 Necessary	Cost Estimate:	\$2,500.00	Status:	
Implementation Priority:	4	Facility Function:			
Implementation Phase:		Implementation Date:			
Official Responsible:

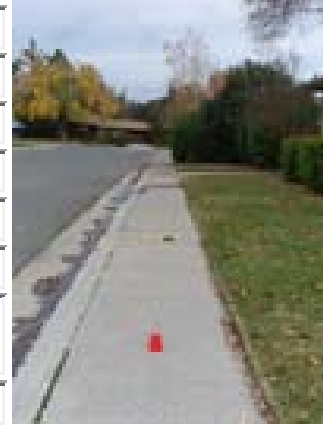
Barrier Type: Cross Slope - Existing (5.0% or more)

Description: Cross slope exceeds 2.0% (5.0% or more)

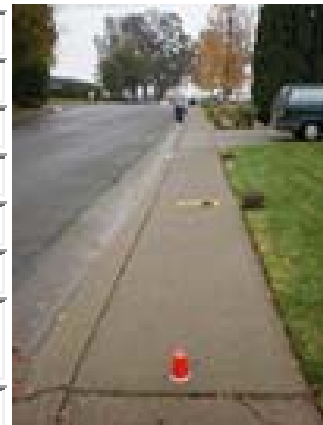
Barrier Type: Cross Slope - Existing (5.0% or more)

Description: Cross slope exceeds 2.0% (5.0% or more)

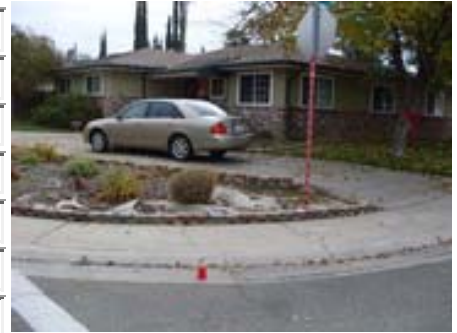
Field Date:	12/2/2010	Report Date:	12/3/2010	Barrier #:	3088
Location:	Mercedes Ave and Binet Dr - Corner C				
X Coordinate:	-121.30475				
Y Coordinate:	38.68047				
Barrier Area:	Curb Ramps				
Barrier Type:	No Curb Ramp				
Code Ref:	CBC 1127B.5.1 and ADA/ABA 402.2

As Built Meas:	1	Quantity:	EACH		
Description:	No curb cut at corner (intersection)				
As Built Desc:	No curb ramp at corner				
Solution:	Demolish existing and construct curb cut				
Bar. Severity:	1 Necessary	Cost Estimate:	\$2,500.00	Status:	
Implementation Priority:	3	Facility Function:			
Implementation Phase:		Implementation Date:			
Official Responsible:

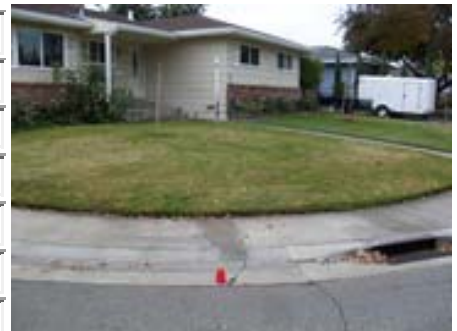
Field Date:	12/2/2010	Report Date:	12/3/2010	Barrier #:	3089
Location:	Mercedes Ave and Binet Dr - Corner D				
X Coordinate:	-121.30483				
Y Coordinate:	38.68046				
Barrier Area:	Curb Ramps				
Barrier Type:	No Curb Ramp				
Code Ref:	CBC 1127B.5.1 and ADA/ABA 402.2

As Built Meas:	1	Quantity:	EACH		
Description:	No curb cut at corner (intersection)				
As Built Desc:	No curb ramp at corner				
Solution:	Demolish existing and construct curb cut				
Bar. Severity:	1 Necessary	Cost Estimate:	\$2,500.00	Status:	
Implementation Priority:	3	Facility Function:			
Implementation Phase:		Implementation Date:			
Official Responsible:

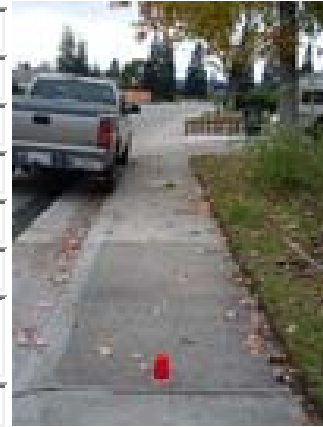
Field Date:	12/2/2010	Report Date:	12/3/2010	Barrier #:	3090
Location:	Binet Dr - West				
X Coordinate:	-121.30473				
Y Coordinate:	38.68021				
Barrier Area:	Sidewalks				
Barrier Type:	Cross Slope - Existing (5.0% or more)				
Code Ref:	CBC 1133B.7.1.3 and ADA/ABA 403.3

As Built Meas:	379	Quantity:	LF	
Description:	Cross slope exceeds 2.0% (5.0% or more)			
As Built Desc:	6.1% cross slope			
Solution:	Demolish existing and construct new route			
Bar. Severity:	1 Necessary	Cost Estimate:	\$47,375.00	Status:
Implementation Priority:	4	Facility Function:		
Implementation Phase:		Implementation Date:		
Official Responsible:

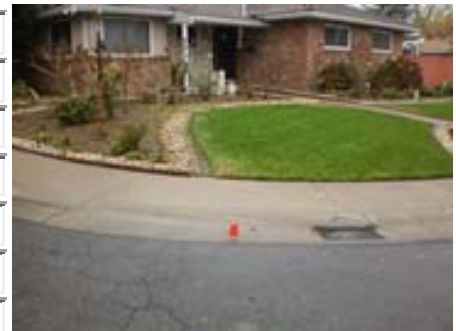
Field Date:	12/2/2010	Report Date:	12/3/2010	Barrier #:	3091
Location:	Binet Dr and Le Mans Ave - Corner A				
X Coordinate:	-121.30442				
Y Coordinate:	38.67924				
Barrier Area:	Curb Ramps				
Barrier Type:	No Curb Ramp				
Code Ref:	CBC 1127B.5.1 and ADA/ABA 402.2

As Built Meas:	1	Quantity:	EACH	
Description:	No curb cut at corner (intersection)			
As Built Desc:	No curb ramp at corner			
Solution:	Demolish existing and construct curb cut			
Bar. Severity:	1 Necessary	Cost Estimate:	\$2,500.00	Status:
Implementation Priority:	4	Facility Function:		
Implementation Phase:		Implementation Date:		
Official Responsible:

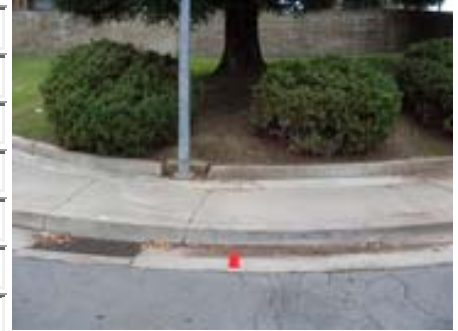
Barrier Type: No Curb Ramp

Description: No curb cut at corner (intersection)

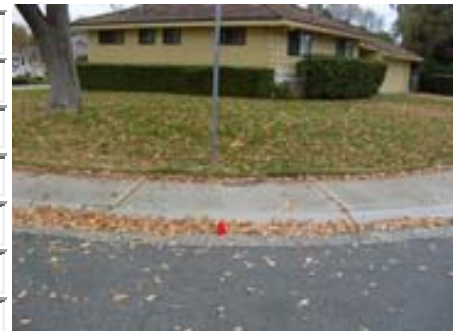
Barrier Type: No Curb Ramp

Description: No curb cut at corner (intersection)

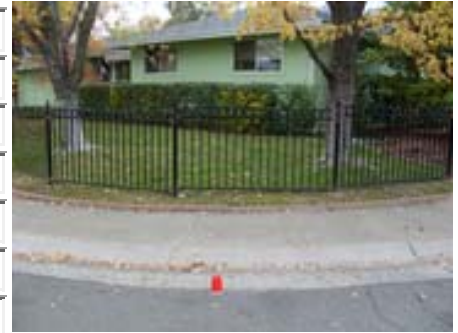
Field Date:	12/2/2010	Report Date:	12/3/2010	Barrier #:	3094
Location:	Le Mans Ave and Shalimar Wy - Corner B				
X Coordinate:	-121.30512				
Y Coordinate:	38.67901				
Barrier Area:	Curb Ramps				
Barrier Type:	No Curb Ramp				
Code Ref:	CBC 1127B.5.1 and ADA/ABA 402.2

As Built Meas:	1	Quantity:	EACH	
Description:	No curb cut at corner (intersection)			
As Built Desc:	No curb ramp at corner			
Solution:	Demolish existing and construct curb cut			
Bar. Severity:	1 Necessary	Cost Estimate:	\$2,500.00	Status:
Implementation Priority:	4	Facility Function:		
Implementation Phase:		Implementation Date:		
Official Responsible:

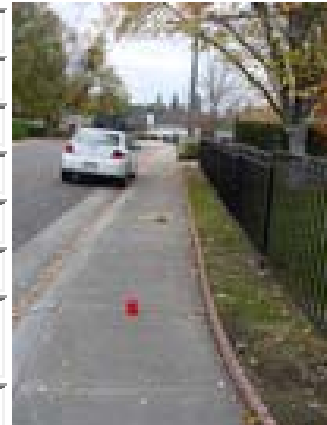
Field Date:	12/2/2010	Report Date:	12/3/2010	Barrier #:	3095
Location:	Shalimar Dr - East				
X Coordinate:	-121.30525				
Y Coordinate:	38.67927				
Barrier Area:	Sidewalks				
Barrier Type:	Cross Slope - Existing (5.0% or more)				
Code Ref:	CBC 1133B.7.1.3 and ADA/ABA 403.3

As Built Meas:	246	Quantity:	LF	
Description:	Cross slope exceeds 2.0% (5.0% or more)			
As Built Desc:	7.0% cross slope			
Solution:	Demolish existing and construct new route			
Bar. Severity:	1 Necessary	Cost Estimate:	\$30,750.00	Status:
Implementation Priority:	4	Facility Function:		
Implementation Phase:		Implementation Date:		
Official Responsible:

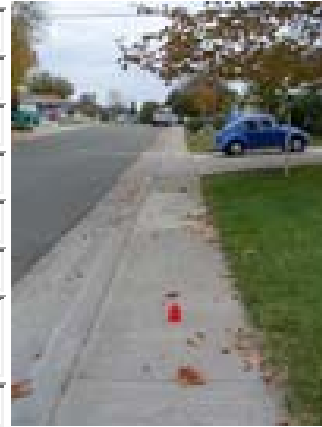
Field Date:	12/2/2010	Report Date:	12/3/2010	Barrier #:	3096
Location:	Shalimar Dr - North				
X Coordinate:	-121.30578				
Y Coordinate:	38.67971				
Barrier Area:	Sidewalks				
Barrier Type:	Cross Slope - Existing (5.0% or more)				
Code Ref:	CBC 1133B.7.1.3 and ADA/ABA 403.3

As Built Meas:	674	Quantity:	LF
Description:	Cross slope exceeds 2.0% (5.0% or more)		
As Built Desc:	5.9% cross slope		
Solution:	Demolish existing and construct new route		
Bar. Severity:	1 Necessary	Cost Estimate:	\$84,250.00
Implementation Priority:	4	Facility Function:	
Implementation Phase:		Implementation Date:	
Official Responsible:

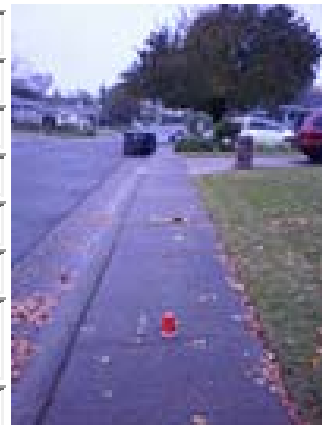
Field Date:	12/2/2010	Report Date:	12/3/2010	Barrier #:	3097A
Location:	Shalimar Dr - South				
X Coordinate:	-121.30774				
Y Coordinate:	38.67973				
Barrier Area:	Sidewalks				
Barrier Type:	Cross Slope - Existing (5.0% or more)				
Code Ref:	CBC 1133B.7.1.3 and ADA/ABA 403.3

As Built Meas:	611	Quantity:	LF
Description:	Cross slope exceeds 2.0% (5.0% or more)		
As Built Desc:	5.8% cross slope		
Solution:	Demolish existing and construct new route		
Bar. Severity:	1 Necessary	Cost Estimate:	\$76,375.00
Implementation Priority:	4	Facility Function:	
Implementation Phase:		Implementation Date:	
Official Responsible:

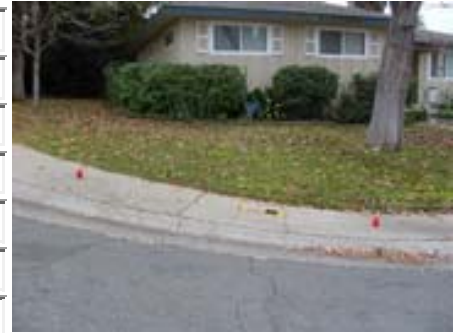
Field Date:	12/2/2010	Report Date:	12/3/2010	Barrier #:	3097B
Location:	Shalimar Dr - South				
X Coordinate:	-121.30556				
Y Coordinate:	38.67965				
Barrier Area:	Sidewalks				
Barrier Type:	Running Slope (Existing)				
Code Ref:	CBC 1133B.7.3 and ADA/ABA 403.3

As Built Meas:	12	Quantity:	LF
Description:	Running slope exceeds 5.0%		
As Built Desc:	13.4% running slope		
Solution:	No remediation where sidewalk sloped as roadway		
Bar. Severity:	5 Technically Infeasible	Cost Estimate:	\$0.00
Implementation Priority:	4	Facility Function:	
Implementation Phase:		Implementation Date:	
Official Responsible:

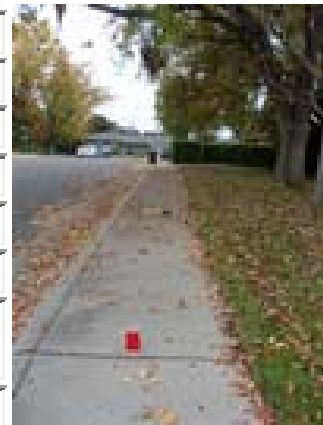
Field Date:	12/2/2010	Report Date:	12/3/2010	Barrier #:	3098A
Location:	Shalimar Dr - West				
X Coordinate:	-121.30551				
Y Coordinate:	38.6796				
Barrier Area:	Sidewalks				
Barrier Type:	Cross Slope - Existing (5.0% or more)				
Code Ref:	CBC 1133B.7.1.3 and ADA/ABA 403.3

As Built Meas:	229	Quantity:	LF
Description:	Cross slope exceeds 2.0% (5.0% or more)		
As Built Desc:	5.6% cross slope		
Solution:	Demolish existing and construct new route		
Bar. Severity:	1 Necessary	Cost Estimate:	\$28,625.00
Implementation Priority:	4	Facility Function:	
Implementation Phase:		Implementation Date:	
Official Responsible:

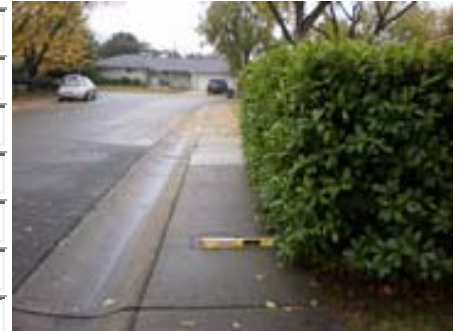
Field Date:	12/2/2010	Report Date:	12/3/2010	Barrier #:	3098B
Location:	Shalimar Dr - West				
X Coordinate:	-121.30538				
Y Coordinate:	38.67932				
Barrier Area:	Sidewalks				
Barrier Type:	Clear Width - Existing ( $\leq 31"$ or less)				
Code Ref:	CBC 1133B.7.1

As Built Meas:	2	Quantity:	LF
Description:	Pedestrian route is not min. 48" wide ( $\leq 31"$ or less)		
As Built Desc:	31" clear width due to foliage		
Solution:	Trim foliage		
Bar. Severity:	1 Necessary	Cost Estimate:	\$125.00
Implementation Priority:	4	Facility Function:	
Implementation Phase:		Implementation Date:	
Official Responsible:

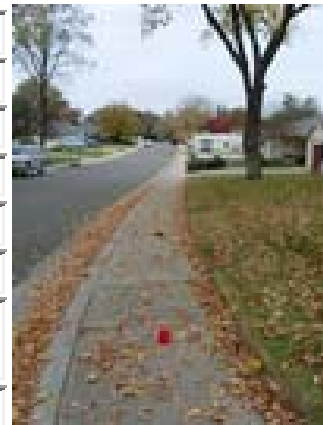
Field Date:	12/2/2010	Report Date:	12/3/2010	Barrier #:	3099
Location:	Le Mans Ave - North				
X Coordinate:	-121.30538				
Y Coordinate:	38.67902				
Barrier Area:	Sidewalks				
Barrier Type:	Cross Slope - Existing (5.0% or more)				
Code Ref:	CBC 1133B.7.1.3 and ADA/ABA 403.3

As Built Meas:	697	Quantity:	LF
Description:	Cross slope exceeds 2.0% (5.0% or more)		
As Built Desc:	5.0% cross slope		
Solution:	Demolish existing and construct new route		
Bar. Severity:	1 Necessary	Cost Estimate:	\$87,125.00
Implementation Priority:	4	Facility Function:	
Implementation Phase:		Implementation Date:	
Official Responsible:

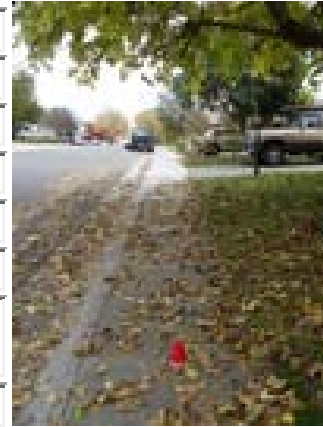
Barrier Type: Cross Slope - Existing (5.0% or more)

Code Ref: CBC 1133B.7.1.3 and ADA/ABA 403.3

As Built Meas: 961 Quantity: LF

Description: Cross slope exceeds 2.0% (5.0% or more)

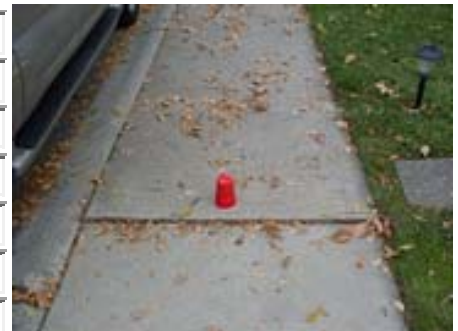
Barrier Type: Abrupt Change in Level - > 1/2"

Code Ref: CBC 1133B.7.1 and ADA/ABA 303.3

As Built Meas: 4 Quantity: LF

Description: Change in level greater than 1/2"

Solution: Grind or repair sidewalk to remove trip hazard

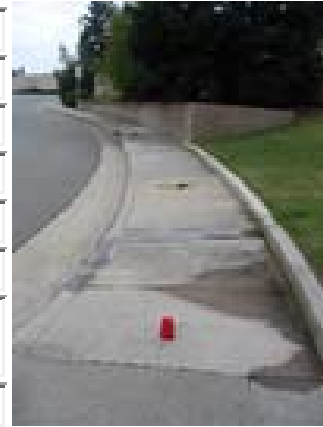
Field Date: 12/2/2010 Report Date: 12/3/2010 Barrier #: 3101  
 Location: Binet Dr - West  
 X Coordinate: -121.30424  
 Y Coordinate: 38.67912  
 Barrier Area: Sidewalks  
 Barrier Type: Driveway - Existing (5.0% or more)  
 Code Ref: CBC 1133B.7.1.3 and ADA/ABA 403.3

As Built Meas: 42 Quantity: LF  
 Description: Driveway cross slope exceeds 2.0% (5.0% or more)  
 As Built Desc: 9.9% cross slope, 9.8% running slope  
 Solution: Provide min. 48" wide level walkway through driveway  
 Bar. Severity: 1 Necessary Cost Estimate: \$5,250.00 Status:  
 Implementation Priority: 4 Facility Function:  
 Implementation Phase: Implementation Date:  
 Official Responsible:

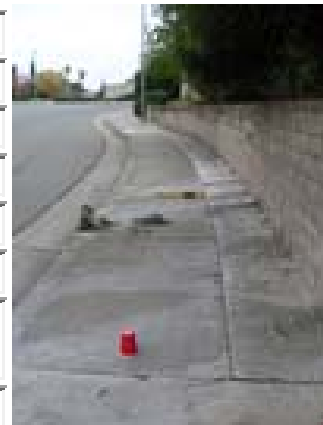
Field Date: 12/2/2010 Report Date: 12/3/2010 Barrier #: 3102  
 Location: Binet Dr - West  
 X Coordinate: -121.3041  
 Y Coordinate: 38.67905  
 Barrier Area: Sidewalks  
 Barrier Type: Cross Slope - Existing (3.1% to 4.0%)  
 Code Ref: CBC 1133B.7.1.3 and ADA/ABA 403.3

As Built Meas: 265 Quantity: LF  
 Description: Cross slope exceeds 2.0% (3.1% to 4.0%)  
 As Built Desc: 4.0% cross slope  
 Solution: Demolish existing and construct new route  
 Bar. Severity: 3 Hinderance Cost Estimate: \$33,125.00 Status:  
 Implementation Priority: 4 Facility Function:  
 Implementation Phase: Implementation Date:  
 Official Responsible:

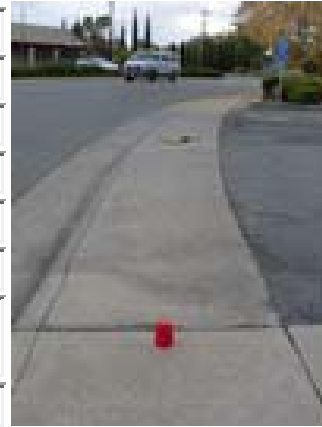
Barrier Type: Driveway - Existing (5.0% or more)

Code Ref: CBC 1133B.7.1.3 and ADA/ABA 403.3

As Built Meas: 42 Quantity: LF

Description: Driveway cross slope exceeds 2.0% (5.0% or more)

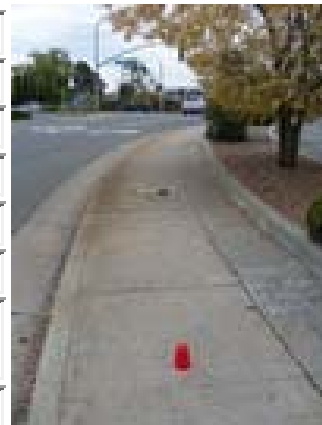
Barrier Type: Cross Slope - Existing (4.1% to 4.9%)

Code Ref: CBC 1133B.7.1.3 and ADA/ABA 403.3

As Built Meas: 153 Quantity: LF

Description: Cross slope exceeds 2.0% (4.1% to 4.9%)

Bar. Severity: 2 Recommended Cost Estimate: \$19,125.00 Status:

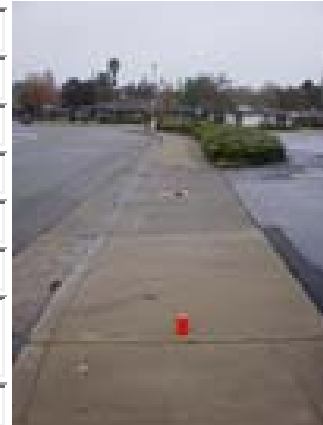
Field Date:	12/2/2010	Report Date:	12/3/2010	Barrier #:	3105
Location:	Binet Dr - East				
X Coordinate:	-121.30344				
Y Coordinate:	38.67827				
Barrier Area:	Sidewalks				
Barrier Type:	Driveway - Existing (5.0% or more)				
Code Ref:	CBC 1133B.7.1.3 and ADA/ABA 403.3

As Built Meas:	42	Quantity:	LF		
Description:	Driveway cross slope exceeds 2.0% (5.0% or more)				
As Built Desc:	9.5% cross slope, 8.8% running slope				
Solution:	Provide min. 48" wide level walkway through driveway				
Bar. Severity:	1 Necessary	Cost Estimate:	\$5,250.00	Status:	
Implementation Priority:	4	Facility Function:			
Implementation Phase:		Implementation Date:			
Official Responsible:

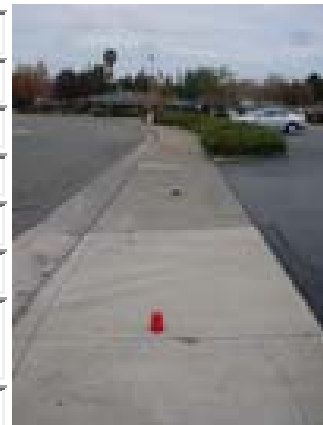
Field Date:	12/2/2010	Report Date:	12/3/2010	Barrier #:	3106
Location:	Binet Dr - East				
X Coordinate:	-121.30346				
Y Coordinate:	38.67874				
Barrier Area:	Sidewalks				
Barrier Type:	Cross Slope - Existing (5.0% or more)				
Code Ref:	CBC 1133B.7.1.3 and ADA/ABA 403.3

As Built Meas:	117	Quantity:	LF		
Description:	Cross slope exceeds 2.0% (5.0% or more)				
As Built Desc:	5.8% cross slope				
Solution:	Demolish existing and construct new route				
Bar. Severity:	1 Necessary	Cost Estimate:	\$14,625.00	Status:	
Implementation Priority:	4	Facility Function:			
Implementation Phase:		Implementation Date:			
Official Responsible:

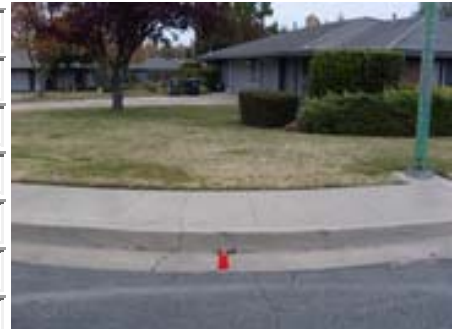
Field Date:	12/2/2010	Report Date:	12/3/2010	Barrier #:	3108
Location:	Binet Dr and Burnham Dr - Corner C				
X Coordinate:	-121.30351				
Y Coordinate:	38.67885				
Barrier Area:	Curb Ramps				
Barrier Type:	No Curb Ramp				
Code Ref:	CBC 1127B.5.1 and ADA/ABA 402.2

As Built Meas:	1	Quantity:	EACH		
Description:	No curb cut at corner (intersection)				
As Built Desc:	No curb ramp at corner				
Solution:	Demolish existing and construct curb cut				
Bar. Severity:	1 Necessary	Cost Estimate:	\$2,500.00	Status:	
Implementation Priority:	4	Facility Function:			
Implementation Phase:		Implementation Date:			
Official Responsible:

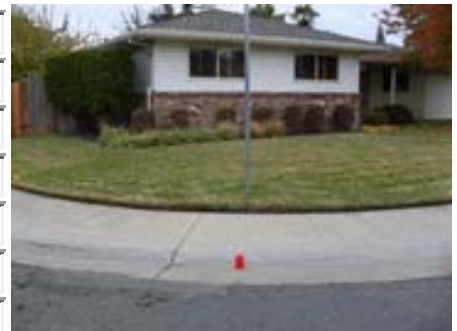
Field Date:	12/2/2010	Report Date:	12/3/2010	Barrier #:	3112
Location:	Binet Dr and Le Havre Wy - Corner B				
X Coordinate:	-121.30449				
Y Coordinate:	38.67993				
Barrier Area:	Curb Ramps				
Barrier Type:	No Curb Ramp				
Code Ref:	CBC 1127B.5.1 and ADA/ABA 402.2

As Built Meas:	1	Quantity:	EACH	
Description:	No curb cut at corner (intersection)			
As Built Desc:	No curb ramp at corner			
Solution:	Demolish existing and construct curb cut			
Bar. Severity:	1 Necessary	Cost Estimate:	\$2,500.00	Status:
Implementation Priority:	4	Facility Function:		
Implementation Phase:		Implementation Date:		
Official Responsible:

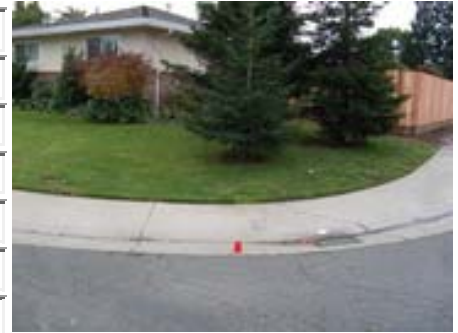
Field Date:	12/2/2010	Report Date:	12/3/2010	Barrier #:	3113
Location:	Binet Dr and Le Havre Wy - Corner C				
X Coordinate:	-121.30445				
Y Coordinate:	38.67982				
Barrier Area:	Curb Ramps				
Barrier Type:	No Curb Ramp				
Code Ref:	CBC 1127B.5.1 and ADA/ABA 402.2

As Built Meas:	1	Quantity:	EACH	
Description:	No curb cut at corner (intersection)			
As Built Desc:	No curb ramp at corner			
Solution:	Demolish existing and construct curb cut			
Bar. Severity:	1 Necessary	Cost Estimate:	\$2,500.00	Status:
Implementation Priority:	4	Facility Function:		
Implementation Phase:		Implementation Date:		
Official Responsible:

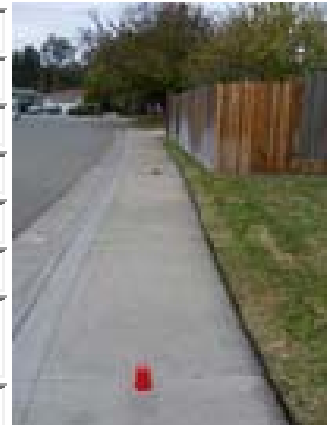
Field Date:	12/2/2010	Report Date:	12/3/2010	Barrier #:	3114
Location:	Binet Dr - East				
X Coordinate:	-121.30455				
Y Coordinate:	38.68007				
Barrier Area:	Sidewalks				
Barrier Type:	Cross Slope - Existing (3.1% to 4.0%)				
Code Ref:	CBC 1133B.7.1.3 and ADA/ABA 403.3

As Built Meas:	177	Quantity:	LF	
Description:	Cross slope exceeds 2.0% (3.1% to 4.0%)			
As Built Desc:	3.9% cross slope			
Solution:	Demolish existing and construct new route			
Bar. Severity:	3 Hinderance	Cost Estimate:	\$22,125.00	Status:
Implementation Priority:	4	Facility Function:		
Implementation Phase:		Implementation Date:		
Official Responsible:

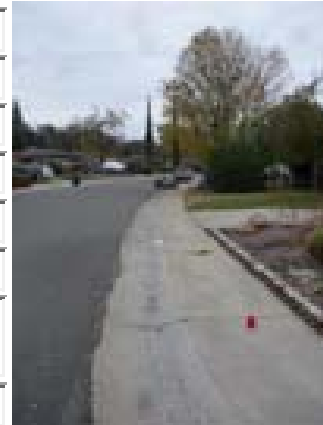
Field Date:	12/2/2010	Report Date:	12/3/2010	Barrier #:	3115
Location:	Mercedes Ave - South				
X Coordinate:	-121.30464				
Y Coordinate:	38.6805				
Barrier Area:	Sidewalks				
Barrier Type:	Cross Slope - Existing (5.0% or more)				
Code Ref:	CBC 1133B.7.1.3 and ADA/ABA 403.3

As Built Meas:	1077	Quantity:	LF	
Description:	Cross slope exceeds 2.0% (5.0% or more)			
As Built Desc:	5.0% cross slope			
Solution:	Demolish existing and construct new route			
Bar. Severity:	1 Necessary	Cost Estimate:	\$134,625.00	Status:
Implementation Priority:	3	Facility Function:		
Implementation Phase:		Implementation Date:		
Official Responsible:

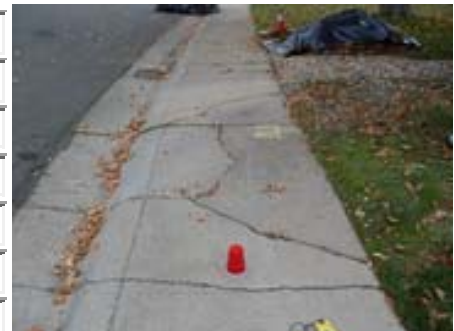
Field Date:	12/2/2010	Report Date:	12/3/2010	Barrier #:	3116
Location:	Mercedes Ave - South				
X Coordinate:	-121.30438				
Y Coordinate:	38.68054				
Barrier Area:	Sidewalks				
Barrier Type:	Surface Condition - Damaged				
Code Ref:	CBC 1133B.7.1 and ADA/ABA 302.1

As Built Meas:	8	Quantity:	LF	
Description:	Surface is not firm and stable (cracked, broken or loose soil, etc.)			
As Built Desc:	Cracked concrete			
Solution:	Repair surface to make firm and stable			
Bar. Severity:	1 Necessary	Cost Estimate:	\$1,000.00	Status:
Implementation Priority:	3	Facility Function:		
Implementation Phase:		Implementation Date:		
Official Responsible:

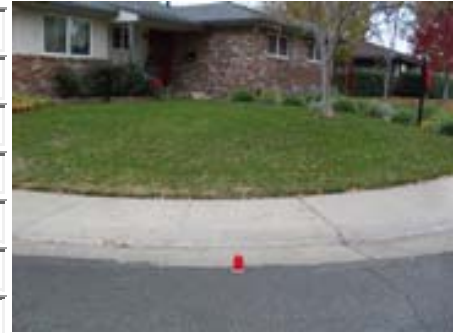
Field Date:	12/2/2010	Report Date:	12/3/2010	Barrier #:	3117
Location:	Mercedes Ave and Le Havre Wy - Corner C				
X Coordinate:	-121.30077				
Y Coordinate:	38.68059				
Barrier Area:	Curb Ramps				
Barrier Type:	No Curb Ramp				
Code Ref:	CBC 1127B.5.1 and ADA/ABA 402.2

As Built Meas:	1	Quantity:	EACH	
Description:	No curb cut at corner (intersection)			
As Built Desc:	No curb ramp at corner			
Solution:	Demolish existing and construct curb cut			
Bar. Severity:	1 Necessary	Cost Estimate:	\$2,500.00	Status:
Implementation Priority:	3	Facility Function:		
Implementation Phase:		Implementation Date:		
Official Responsible:
