**DRAFT ADA TRANSITION PLAN UPDATE  
NEIGHBORHOOD AREA 4 ARCADE CREEK  
SEPTEMBER 20, 2011**

CITY OF CITRUS HEIGHTS

## Arcade Creek Neighborhood Area

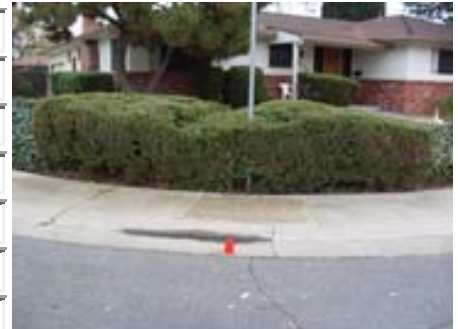
Field Date:	12/2/2010	Report Date:	12/3/2010	Barrier #:	3118
Location:	Mercedes Ave and Le Havre Wy - Corner D				
X Coordinate:	-121.30088				
Y Coordinate:	38.68059				
Barrier Area:	Curb Ramps				
Barrier Type:	No Curb Ramp				
Code Ref:	CBC 1127B.5.1 and ADA/ABA 402.2

As Built Meas:	1	Quantity:	EACH	
Description:	No curb cut at corner (intersection)			
As Built Desc:	No curb ramp at corner			
Solution:	Demolish existing and construct curb cut			
Bar. Severity:	1 Necessary	Cost Estimate:	\$2,500.00	Status:
Implementation Priority:	3	Facility Function:		
Implementation Phase:		Implementation Date:		
Official Responsible:

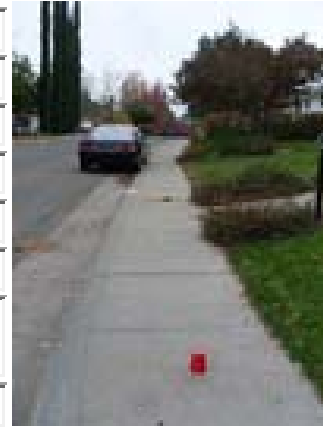
Field Date:	12/2/2010	Report Date:	12/3/2010	Barrier #:	3119
Location:	Le Havre Wy - West				
X Coordinate:	-121.30088				
Y Coordinate:	38.68016				
Barrier Area:	Sidewalks				
Barrier Type:	Cross Slope - Existing (4.1% to 4.9%)				
Code Ref:	CBC 1133B.7.1.3 and ADA/ABA 403.3

As Built Meas:	53	Quantity:	LF	
Description:	Cross slope exceeds 2.0% (4.1% to 4.9%)			
As Built Desc:	4.8% cross slope			
Solution:	Demolish existing and construct new route			
Bar. Severity:	2 Recommended	Cost Estimate:	\$6,625.00	Status:
Implementation Priority:	4	Facility Function:		
Implementation Phase:		Implementation Date:		
Official Responsible:

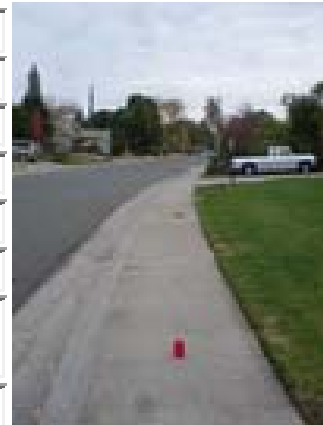
Field Date:	12/2/2010	Report Date:	12/3/2010	Barrier #:	3120
Location:	Le Havre Wy - North				
X Coordinate:	-121.30123				
Y Coordinate:	38.68001				
Barrier Area:	Sidewalks				
Barrier Type:	Cross Slope - Existing (4.1% to 4.9%)				
Code Ref:	CBC 1133B.7.1.3 and ADA/ABA 403.3

As Built Meas:	996	Quantity:	LF	
Description:	Cross slope exceeds 2.0% (4.1% to 4.9%)			
As Built Desc:	4.4% cross slope			
Solution:	Demolish existing and construct new route			
Bar. Severity:	2 Recommended	Cost Estimate:	\$124,500.00	Status:
Implementation Priority:	4	Facility Function:		
Implementation Phase:		Implementation Date:		
Official Responsible:

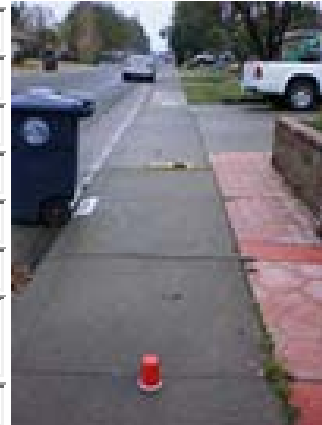
Field Date:	12/2/2010	Report Date:	12/3/2010	Barrier #:	3121A
Location:	Le Havre Wy - South				
X Coordinate:	-121.30428				
Y Coordinate:	38.67983				
Barrier Area:	Sidewalks				
Barrier Type:	Cross Slope - Existing (4.1% to 4.9%)				
Code Ref:	CBC 1133B.7.1.3 and ADA/ABA 403.3

As Built Meas:	1027	Quantity:	LF
Description:	Cross slope exceeds 2.0% (4.1% to 4.9%)		
As Built Desc:	4.3% cross slope		
Solution:	Demolish existing and construct new route		
Bar. Severity:	2 Recommended	Cost Estimate:	\$128,375.00
Implementation Priority:	4	Facility Function:	
Implementation Phase:		Implementation Date:	
Official Responsible:

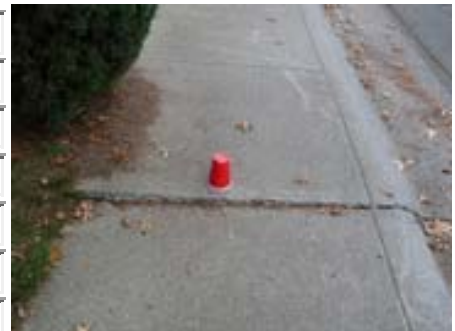
Field Date:	12/2/2010	Report Date:	12/3/2010	Barrier #:	3121B
Location:	Le Havre Wy - South				
X Coordinate:	-121.30142				
Y Coordinate:	38.67988				
Barrier Area:	Sidewalks				
Barrier Type:	Abrupt Change in Level - > 1/2"				
Code Ref:	CBC 1133B.7.1 and ADA/ABA 303.3

As Built Meas:	4	Quantity:	LF
Description:	Change in level greater than 1/2"		
As Built Desc:	1" lip in sidewalk surface		
Solution:	Grind or repair sidewalk to remove trip hazard		
Bar. Severity:	1 Necessary	Cost Estimate:	\$1,000.00
Implementation Priority:	4	Facility Function:	
Implementation Phase:		Implementation Date:	
Official Responsible:

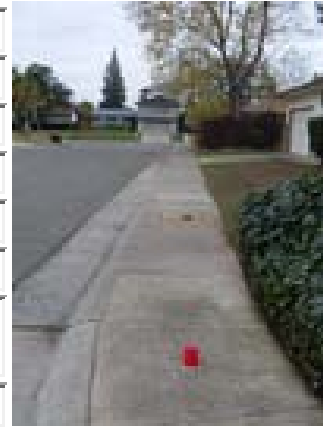
Field Date:	12/2/2010	Report Date:	12/3/2010	Barrier #:	3122
Location:	Le Havre - East				
X Coordinate:	-121.30077				
Y Coordinate:	38.68039				
Barrier Area:	Sidewalks				
Barrier Type:	Cross Slope - Existing (4.1% to 4.9%)				
Code Ref:	CBC 1133B.7.1.3 and ADA/ABA 403.3

As Built Meas:	216	Quantity:	LF	
Description:	Cross slope exceeds 2.0% (4.1% to 4.9%)			
As Built Desc:	4.1% cross slope			
Solution:	Demolish existing and construct new route			
Bar. Severity:	2 Recommended	Cost Estimate:	\$27,000.00	Status:
Implementation Priority:	4	Facility Function:		
Implementation Phase:		Implementation Date:		
Official Responsible:

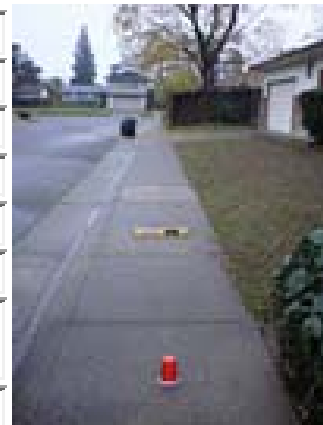
Field Date:	12/2/2010	Report Date:	12/3/2010	Barrier #:	3123
Location:	Mercedes Ave - South				
X Coordinate:	-121.30068				
Y Coordinate:	38.68061				
Barrier Area:	Sidewalks				
Barrier Type:	Cross Slope - Existing (3.1% to 4.0%)				
Code Ref:	CBC 1133B.7.1.3 and ADA/ABA 403.3

As Built Meas:	179	Quantity:	LF	
Description:	Cross slope exceeds 2.0% (3.1% to 4.0%)			
As Built Desc:	3.8% cross slope			
Solution:	Demolish existing and construct new route			
Bar. Severity:	3 Hinderance	Cost Estimate:	\$22,375.00	Status:
Implementation Priority:	3	Facility Function:		
Implementation Phase:		Implementation Date:		
Official Responsible:

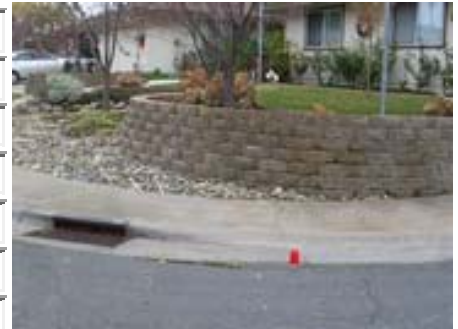
Field Date:	12/2/2010	Report Date:	12/3/2010	Barrier #:	3125
Location:	Mercedes Ave and Burnham Dr - Corner A				
X Coordinate:	-121.3				
Y Coordinate:	38.68069				
Barrier Area:	Curb Ramps				
Barrier Type:	No Curb Ramp				
Code Ref:	CBC 1127B.5.1 and ADA/ABA 402.2

As Built Meas:	1	Quantity:	EACH		
Description:	No curb cut at corner (intersection)				
As Built Desc:	No curb ramp at corner				
Solution:	Demolish existing and construct curb cut				
Bar. Severity:	1 Necessary	Cost Estimate:	\$2,500.00	Status:	
Implementation Priority:	3	Facility Function:			
Implementation Phase:		Implementation Date:			
Official Responsible:

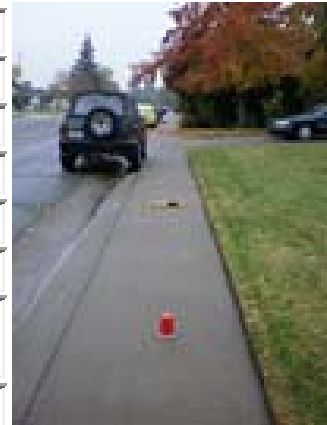
Field Date:	12/2/2010	Report Date:	12/3/2010	Barrier #:	3127
Location:	Burnham Dr - North				
X Coordinate:	-121.30162				
Y Coordinate:	38.67928				
Barrier Area:	Sidewalks				
Barrier Type:	Cross Slope - Existing (3.1% to 4.0%)				
Code Ref:	CBC 1133B.7.1.3 and ADA/ABA 403.3

As Built Meas:	610	Quantity:	LF	
Description:	Cross slope exceeds 2.0% (3.1% to 4.0%)			
As Built Desc:	3.5% cross slope			
Solution:	Demolish existing and construct new route			
Bar. Severity:	3 Hinderance	Cost Estimate:	\$76,250.00	Status:
Implementation Priority:	4	Facility Function:		
Implementation Phase:		Implementation Date:		
Official Responsible:

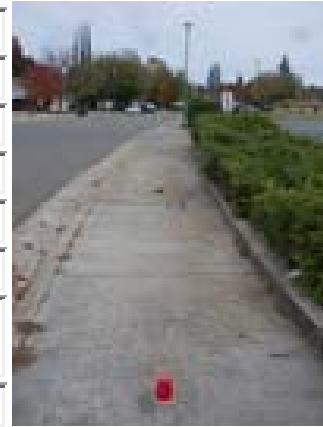
Field Date:	12/2/2010	Report Date:	12/3/2010	Barrier #:	3128
Location:	Burnham Dr - South				
X Coordinate:	-121.30339				
Y Coordinate:	38.67888				
Barrier Area:	Sidewalks				
Barrier Type:	Cross Slope - Existing (3.1% to 4.0%)				
Code Ref:	CBC 1133B.7.1.3 and ADA/ABA 403.3

As Built Meas:	63	Quantity:	LF	
Description:	Cross slope exceeds 2.0% (3.1% to 4.0%)			
As Built Desc:	3.7% cross slope			
Solution:	Demolish existing and construct new route			
Bar. Severity:	3 Hinderance	Cost Estimate:	\$7,875.00	Status:
Implementation Priority:	4	Facility Function:		
Implementation Phase:		Implementation Date:		
Official Responsible:

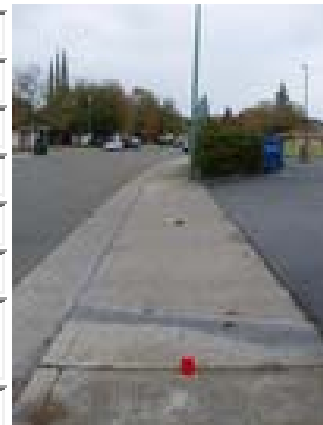
Field Date:	12/2/2010	Report Date:	12/3/2010	Barrier #:	3129
Location:	Burnham Dr - South				
X Coordinate:	-121.30319				
Y Coordinate:	38.67898				
Barrier Area:	Sidewalks				
Barrier Type:	Driveway - Existing (5.0% or more)				
Code Ref:	CBC 1133B.7.1.3 and ADA/ABA 403.3

As Built Meas:	38	Quantity:	LF	
Description:	Driveway cross slope exceeds 2.0% (5.0% or more)			
As Built Desc:	7.6% cross slope			
Solution:	Provide min. 48" wide level walkway through driveway			
Bar. Severity:	4 Low Severity	Cost Estimate:	\$4,750.00	Status:
Implementation Priority:	4	Facility Function:		
Implementation Phase:		Implementation Date:		
Official Responsible:

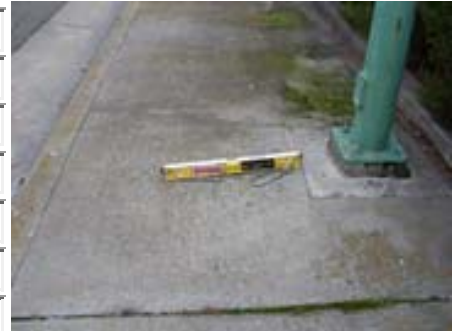
Field Date:	12/2/2010	Report Date:	12/3/2010	Barrier #:	3130
Location:	Burnham Dr - South				
X Coordinate:	-121.30307				
Y Coordinate:	38.67901				
Barrier Area:	Sidewalks				
Barrier Type:	Cross Slope - Existing (5.0% or more)				
Code Ref:	CBC 1133B.7.1.3 and ADA/ABA 403.3

As Built Meas:	8	Quantity:	LF		
Description:	Cross slope exceeds 2.0% (5.0% or more)				
As Built Desc:	12.2% cross slope				
Solution:	Demolish existing and construct new route				
Bar. Severity:	1 Necessary	Cost Estimate:	\$1,000.00	Status:	
Implementation Priority:	4	Facility Function:			
Implementation Phase:		Implementation Date:			
Official Responsible:

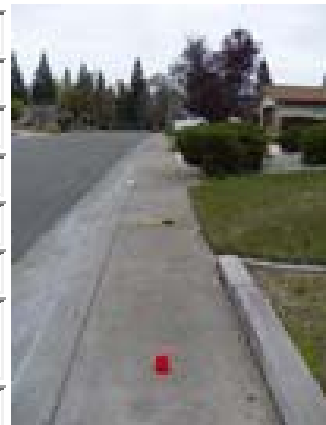
Field Date:	12/2/2010	Report Date:	12/3/2010	Barrier #:	3131
Location:	Burnham Dr - South				
X Coordinate:	-121.30299				
Y Coordinate:	38.67906				
Barrier Area:	Sidewalks				
Barrier Type:	Cross Slope - Existing (4.1% to 4.9%)				
Code Ref:	CBC 1133B.7.1.3 and ADA/ABA 403.3

As Built Meas:	337	Quantity:	LF		
Description:	Cross slope exceeds 2.0% (4.1% to 4.9%)				
As Built Desc:	4.8% cross slope				
Solution:	Demolish existing and construct new route				
Bar. Severity:	2 Recommended	Cost Estimate:	\$42,125.00	Status:	
Implementation Priority:	4	Facility Function:			
Implementation Phase:		Implementation Date:			
Official Responsible:

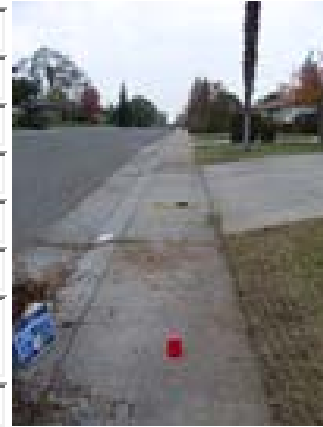
Field Date:	12/2/2010	Report Date:	12/3/2010	Barrier #:	3132
Location:	Burnham Dr - East				
X Coordinate:	-121.30115				
Y Coordinate:	38.6792				
Barrier Area:	Sidewalks				
Barrier Type:	Cross Slope - Existing (3.1% to 4.0%)				
Code Ref:	CBC 1133B.7.1.3 and ADA/ABA 403.3

As Built Meas:	386	Quantity:	LF	
Description:	Cross slope exceeds 2.0% (3.1% to 4.0%)			
As Built Desc:	3.8% cross slope			
Solution:	Demolish existing and construct new route			
Bar. Severity:	3 Hinderance	Cost Estimate:	\$48,250.00	Status:
Implementation Priority:	4	Facility Function:		
Implementation Phase:		Implementation Date:		
Official Responsible:

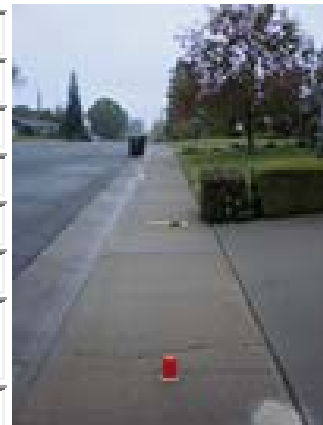
Field Date:	12/2/2010	Report Date:	12/3/2010	Barrier #:	3133
Location:	Mercedes Ave - North				
X Coordinate:	-121.30014				
Y Coordinate:	38.68068				
Barrier Area:	Sidewalks				
Barrier Type:	Cross Slope - Existing (4.1% to 4.9%)				
Code Ref:	CBC 1133B.7.1.3 and ADA/ABA 403.3

As Built Meas:	706	Quantity:	LF	
Description:	Cross slope exceeds 2.0% (4.1% to 4.9%)			
As Built Desc:	4.5% cross slope			
Solution:	Demolish existing and construct new route			
Bar. Severity:	2 Recommended	Cost Estimate:	\$88,250.00	Status:
Implementation Priority:	3	Facility Function:		
Implementation Phase:		Implementation Date:		
Official Responsible:

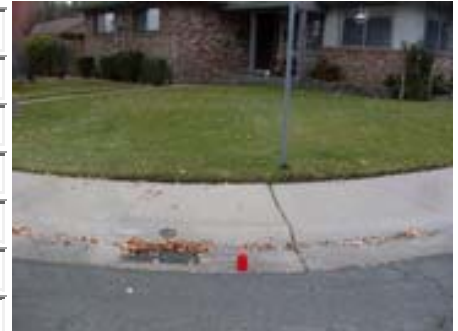
Field Date:	12/2/2010	Report Date:	12/3/2010	Barrier #:	3134
Location:	Mercedes Ave and Dearborn Dr - Corner A				
X Coordinate:	-121.3031				
Y Coordinate:	38.68072				
Barrier Area:	Curb Ramps				
Barrier Type:	No Curb Ramp				
Code Ref:	CBC 1127B.5.1 and ADA/ABA 402.2

As Built Meas:	1	Quantity:	EACH	
Description:	No curb cut at corner (intersection)			
As Built Desc:	No curb ramp at corner			
Solution:	Demolish existing and construct curb cut			
Bar. Severity:	1 Necessary	Cost Estimate:	\$2,500.00	Status:
Implementation Priority:	3	Facility Function:		
Implementation Phase:		Implementation Date:		
Official Responsible:

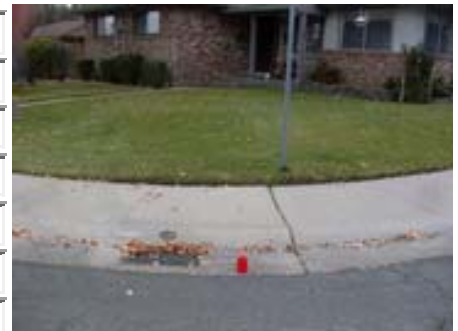
Field Date:	12/2/2010	Report Date:	12/3/2010	Barrier #:	3135
Location:	Mercedes Ave and Dearborn Dr - Corner B				
X Coordinate:	-121.303				
Y Coordinate:	38.68071				
Barrier Area:	Curb Ramps				
Barrier Type:	No Curb Ramp				
Code Ref:	CBC 1127B.5.1 and ADA/ABA 402.2

As Built Meas:	1	Quantity:	EACH	
Description:	No curb cut at corner (intersection)			
As Built Desc:	No curb ramp at corner			
Solution:	Demolish existing and construct curb cut			
Bar. Severity:	1 Necessary	Cost Estimate:	\$2,500.00	Status:
Implementation Priority:	3	Facility Function:		
Implementation Phase:		Implementation Date:		
Official Responsible:

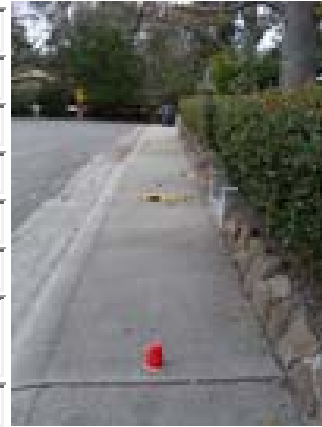
Barrier Type: Cross Slope - Existing (4.1% to 4.9%)

Description: Cross slope exceeds 2.0% (4.1% to 4.9%)

Bar. Severity: 2 Recommended Cost Estimate: \$12,250.00 Status:

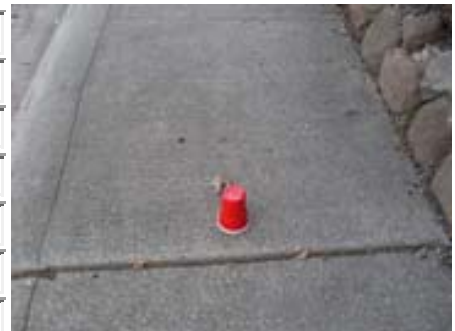
Barrier Type: Abrupt Change in Level - > 1/2"

Description: Change in level greater than 1/2"

Solution: Grind or repair sidewalk to remove trip hazard

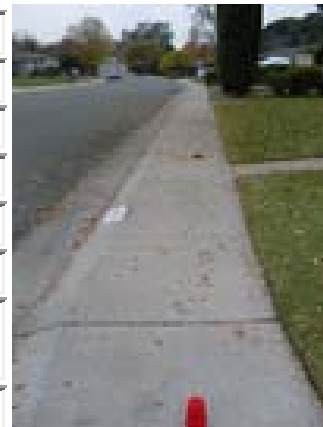
Field Date:	12/2/2010	Report Date:	12/3/2010	Barrier #:	3137
Location:	Mercedes Ave - North				
X Coordinate:	-121.30326				
Y Coordinate:	38.6807				
Barrier Area:	Sidewalks				
Barrier Type:	Cross Slope - Existing (4.1% to 4.9%)				
Code Ref:	CBC 1133B.7.1.3 and ADA/ABA 403.3

As Built Meas:	1582	Quantity:	LF
Description:	Cross slope exceeds 2.0% (4.1% to 4.9%)		
As Built Desc:	4.3% cross slope		
Solution:	Demolish existing and construct new route		
Bar. Severity:	2 Recommended	Cost Estimate:	\$197,750.00
Implementation Priority:	3	Facility Function:	
Implementation Phase:		Implementation Date:	
Official Responsible:

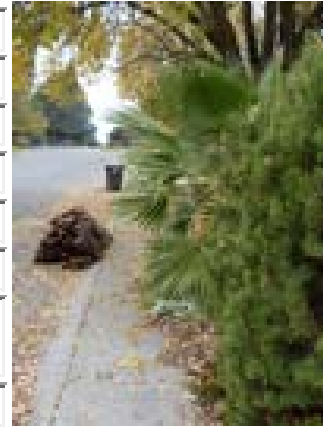
Field Date:	12/2/2010	Report Date:	12/3/2010	Barrier #:	3138
Location:	Mercedes Ave - North				
X Coordinate:	-121.30805				
Y Coordinate:	38.68043				
Barrier Area:	Sidewalks				
Barrier Type:	Clear Width - Existing ( $\leq 31"$ or less)				
Code Ref:	CBC 1133B.7.1

As Built Meas:	2	Quantity:	LF
Description:	Pedestrian route is not min. 48" wide ( $\leq 31"$ or less)		
As Built Desc:	24" clear width due to foliage		
Solution:	Trim foliage		
Bar. Severity:	1 Necessary	Cost Estimate:	\$125.00
Implementation Priority:	3	Facility Function:	
Implementation Phase:		Implementation Date:	
Official Responsible:

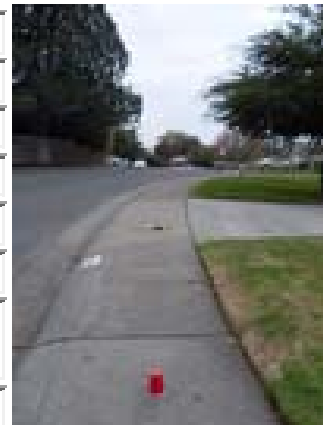
Field Date:	12/2/2010	Report Date:	12/3/2010	Barrier #:	3139
Location:	Mercedes Ave - North				
X Coordinate:	-121.31022				
Y Coordinate:	38.68039				
Barrier Area:	Sidewalks				
Barrier Type:	Cross Slope - Existing (5.0% or more)				
Code Ref:	CBC 1133B.7.1.3 and ADA/ABA 403.3

As Built Meas:	354	Quantity:	LF
Description:	Cross slope exceeds 2.0% (5.0% or more)		
As Built Desc:	5.7% cross slope		
Solution:	Demolish existing and construct new route		
Bar. Severity:	1 Necessary	Cost Estimate:	\$44,250.00
Implementation Priority:	3	Facility Function:	
Implementation Phase:		Implementation Date:	
Official Responsible:

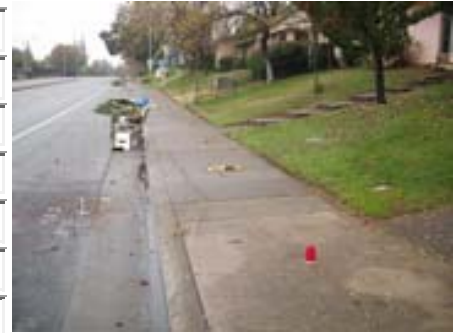
Field Date:	12/3/2010	Report Date:	12/3/2010	Barrier #:	3140
Location:	Van Maren Ln - East				
X Coordinate:	-121.31037				
Y Coordinate:	38.67831				
Barrier Area:	Sidewalks				
Barrier Type:	Cross Slope - Existing (5.0% or more)				
Code Ref:	CBC 1133B.7.1.3 and ADA/ABA 403.3

As Built Meas:	464	Quantity:	LF	
Description:	Cross slope exceeds 2.0% (5.0% or more)			
As Built Desc:	5.0% cross slope			
Solution:	Demolish existing and construct new route			
Bar. Severity:	1 Necessary	Cost Estimate:	\$58,000.00	Status:
Implementation Priority:	1	Facility Function:		
Implementation Phase:		Implementation Date:		
Official Responsible:

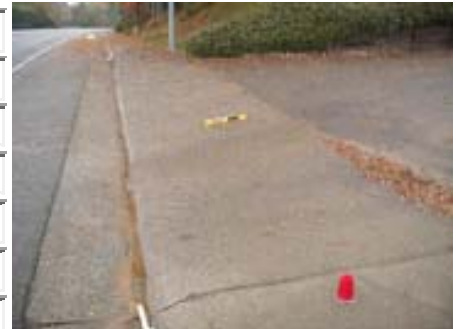
Field Date:	12/3/2010	Report Date:	12/3/2010	Barrier #:	3141
Location:	Van Maren Ln - East				
X Coordinate:	-121.3103				
Y Coordinate:	38.67977				
Barrier Area:	Sidewalks				
Barrier Type:	Driveway - Existing (5.0% or more)				
Code Ref:	CBC 1133B.7.1.3 and ADA/ABA 403.3

As Built Meas:	39	Quantity:	LF	
Description:	Driveway cross slope exceeds 2.0% (5.0% or more)			
As Built Desc:	7.6% cross slope			
Solution:	Provide min. 48" wide level walkway through driveway			
Bar. Severity:	4 Low Severity	Cost Estimate:	\$4,875.00	Status:
Implementation Priority:	1	Facility Function:		
Implementation Phase:		Implementation Date:		
Official Responsible:

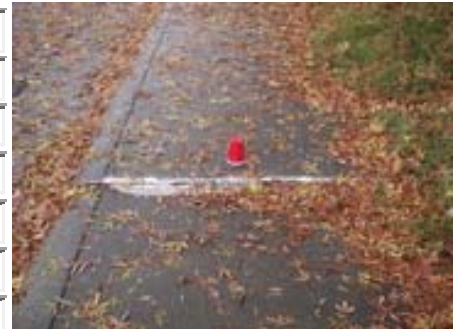
Field Date:	12/3/2010	Report Date:	12/3/2010	Barrier #:	3142B
Location:	Van Maren Ln - East				
X Coordinate:	-121.31036				
Y Coordinate:	38.67986				
Barrier Area:	Sidewalks				
Barrier Type:	Abrupt Change in Level - > 1/2"				
Code Ref:	CBC 1133B.7.1 and ADA/ABA 303.3

As Built Meas:	4	Quantity:	LF		
Description:	Change in level greater than 1/2"				
As Built Desc:	1" lip in sidewalk surface				
Solution:	Grind or repair sidewalk to remove trip hazard				
Bar. Severity:	1 Necessary	Cost Estimate:	\$1,000.00	Status:	
Implementation Priority:	1	Facility Function:			
Implementation Phase:		Implementation Date:			
Official Responsible:

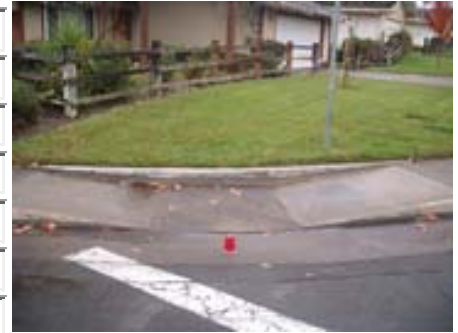
As Built Meas:	1	Quantity:	EACH		
Description:	Ramp run cross slope exceeds 2.0% (9.5% or more)				
As Built Desc:	9.7% running slope				
Solution:	Demolish existing and construct new curb ramp				
Bar. Severity:	1 Necessary	Cost Estimate:	\$2,500.00	Status:	
Implementation Priority:	1	Facility Function:			
Implementation Phase:		Implementation Date:			
Official Responsible:

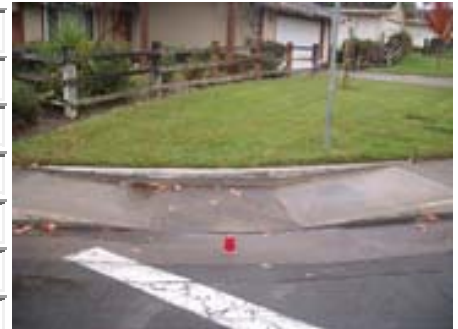
As Built Meas:	1	Quantity:	EACH		
Description:	No truncated domes provided at curb ramp				
As Built Desc:	No detectable warnings at curb ramp				
Solution:	Provide compliant truncated domes				
Bar. Severity:	2 Recommended	Cost Estimate:	\$0.00	Status:	
Implementation Priority:	1	Facility Function:			
Implementation Phase:		Implementation Date:			
Official Responsible:

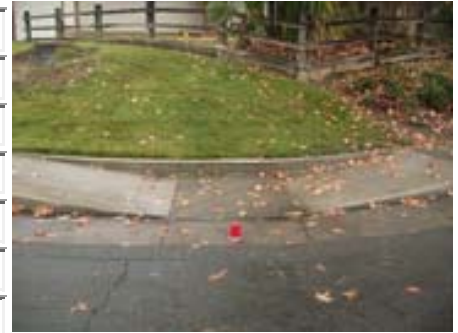
As Built Meas:	1	Quantity:	EACH	
Description:	Ramp run cross slope exceeds 2.0% (9.5% or more)			
As Built Desc:	9.9% running slope			
Solution:	Demolish existing and construct new curb ramp			
Bar. Severity:	1 Necessary	Cost Estimate:	\$2,500.00	Status:
Implementation Priority:	1	Facility Function:		
Implementation Phase:		Implementation Date:		
Official Responsible:

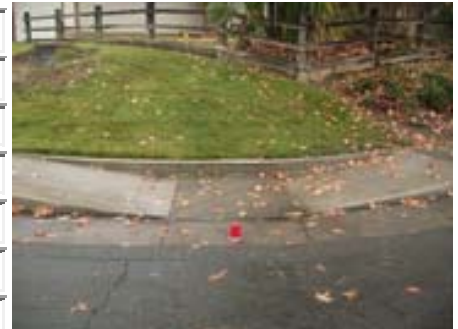
As Built Meas:	1	Quantity:	EACH	
Description:	No truncated domes provided at curb ramp			
As Built Desc:	No detectable warnings at curb ramp			
Solution:	Provide compliant truncated domes			
Bar. Severity:	2 Recommended	Cost Estimate:	\$0.00	Status:
Implementation Priority:	1	Facility Function:		
Implementation Phase:		Implementation Date:		
Official Responsible:

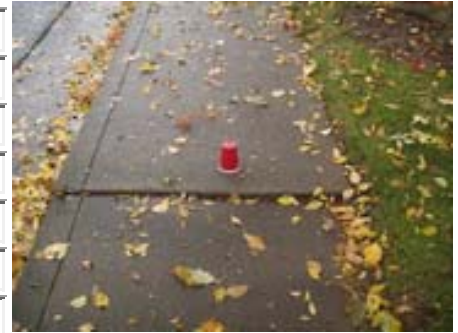
Field Date:	12/3/2010	Report Date:	12/3/2010	Barrier #:	3145
Location:	Van Maren Ln - East				
X Coordinate:	-121.30973				
Y Coordinate:	38.68238				
Barrier Area:	Sidewalks				
Barrier Type:	Abrupt Change in Level - > 1/2"				
Code Ref:	CBC 1133B.7.1 and ADA/ABA 303.3

As Built Meas:	4	Quantity:	LF	
Description:	Change in level greater than 1/2"			
As Built Desc:	1" lip in sidewalk surface			
Solution:	Grind or repair sidewalk to remove trip hazard			
Bar. Severity:	1 Necessary	Cost Estimate:	\$1,000.00	Status:
Implementation Priority:	1	Facility Function:		
Implementation Phase:		Implementation Date:		
Official Responsible:

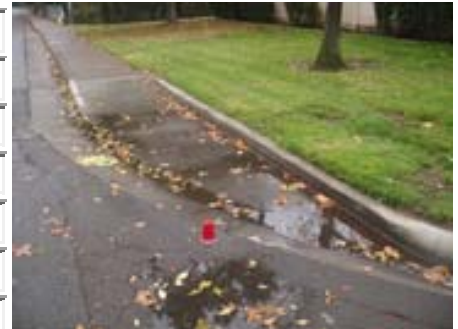
Field Date:	12/3/2010	Report Date:	12/3/2010	Barrier #:	3146A
Location:	Van Maren Ln and Chapel Ct - Corner B				
X Coordinate:	-121.30959				
Y Coordinate:	38.68273				
Barrier Area:	Curb Ramps				
Barrier Type:	Detectable Warnings - Truncated Domes				
Code Ref:	CBC 1127B.5.7 and ADA/ABA 705.1.3

As Built Meas:	1	Quantity:	EACH	
Description:	No truncated domes provided at curb ramp			
As Built Desc:	No detectable warnings at curb ramp			
Solution:	Provide compliant truncated domes			
Bar. Severity:	2 Recommended	Cost Estimate:	\$1,400.00	Status:
Implementation Priority:	1	Facility Function:		
Implementation Phase:		Implementation Date:		
Official Responsible:

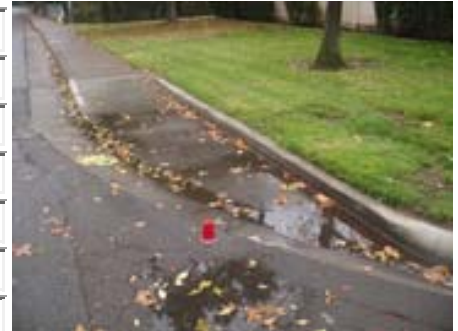
Field Date:	12/3/2010	Report Date:	12/3/2010	Barrier #:	3146B
Location:	Van Maren Ln and Chapel Ct - Corner B				
X Coordinate:	-121.30959				
Y Coordinate:	38.68273				
Barrier Area:	Curb Ramps				
Barrier Type:	Gutter Slope - Existing (6.6% to 8.2%)				
Code Ref:	CBC 1127B.5.3 and ADA/ABA 406.2

As Built Meas:	6	Quantity:	SF	
Description:	Gutter slope exceeds 5.0% (6.6% to 8.2%)			
As Built Desc:	6.8% gutter slope			
Solution:	Demolish existing and construct new gutter			
Bar. Severity:	2 Recommended	Cost Estimate:	\$750.00	Status:
Implementation Priority:	1	Facility Function:		
Implementation Phase:		Implementation Date:		
Official Responsible:

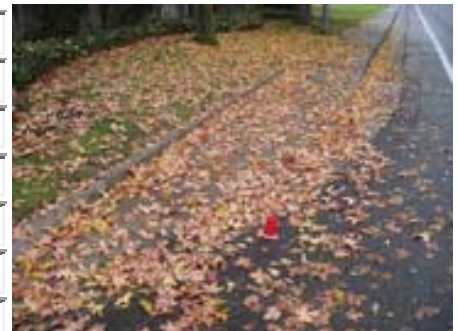
Field Date:	12/3/2010	Report Date:	12/3/2010	Barrier #:	3147A
Location:	Van Maren Ln and Chapel Ct - Corner C				
X Coordinate:	-121.30969				
Y Coordinate:	38.68254				
Barrier Area:	Curb Ramps				
Barrier Type:	Parallel Ramp Landing - Existing (>5.0% or more)				
Code Ref:	CBC 1127B.5.4 and ADA/ABA 406.4

As Built Meas:	1	Quantity:	EACH	
Description:	Curb ramp landing or pan not level (>5.0% or more)			
As Built Desc:	6.8% landing slope			
Solution:	Demolish existing and construct new transition			
Bar. Severity:	1 Necessary	Cost Estimate:	\$250.00	Status:
Implementation Priority:	1	Facility Function:		
Implementation Phase:		Implementation Date:		
Official Responsible:

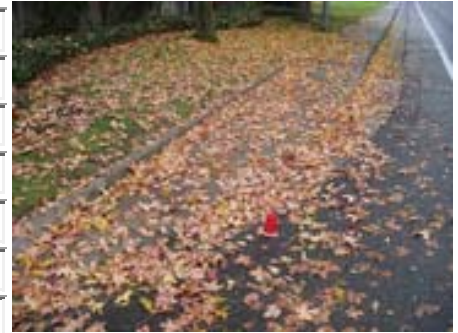
Field Date:	12/3/2010	Report Date:	12/3/2010	Barrier #:	3147B
Location:	Van Maren Ln and Chapel Ct - Corner C				
X Coordinate:	-121.30969				
Y Coordinate:	38.68254				
Barrier Area:	Curb Ramps				
Barrier Type:	Detectable Warnings - Truncated Domes				
Code Ref:	CBC 1127B.5.7 and ADA/ABA 705.1.3

As Built Meas:	1	Quantity:	EACH	
Description:	No truncated domes provided at curb ramp			
As Built Desc:	No detectable warnings at curb ramp			
Solution:	Provide compliant truncated domes			
Bar. Severity:	2 Recommended	Cost Estimate:	\$1,400.00	Status:
Implementation Priority:	1	Facility Function:		
Implementation Phase:		Implementation Date:		
Official Responsible:

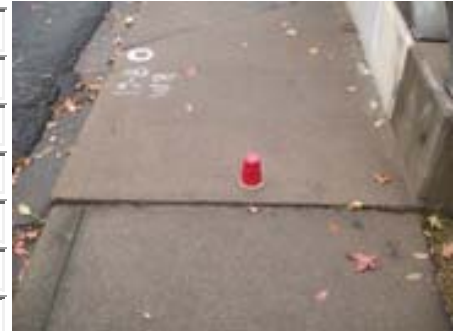
Field Date:	12/3/2010	Report Date:	12/3/2010	Barrier #:	3148
Location:	Van Maren Ln - East				
X Coordinate:	-121.3095				
Y Coordinate:	38.68293				
Barrier Area:	Sidewalks				
Barrier Type:	Abrupt Change in Level - > 1/2"				
Code Ref:	CBC 1133B.7.1 and ADA/ABA 303.3

As Built Meas:	4	Quantity:	LF
Description:	Change in level greater than 1/2"		
As Built Desc:	1" lip in sidewalk surface		
Solution:	Grind or repair sidewalk to remove trip hazard		
Bar. Severity:	1 Necessary	Cost Estimate:	\$1,000.00
Implementation Priority:	1	Facility Function:	
Implementation Phase:		Implementation Date:	
Official Responsible:

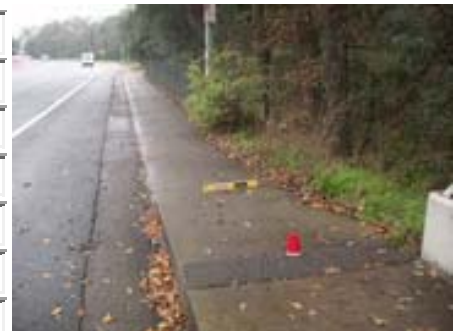
Field Date:	12/3/2010	Report Date:	12/3/2010	Barrier #:	3149
Location:	Van Maren Ln - East				
X Coordinate:	-121.30933				
Y Coordinate:	38.68323				
Barrier Area:	Sidewalks				
Barrier Type:	Cross Slope - Existing (5.0% or more)				
Code Ref:	CBC 1133B.7.1.3 and ADA/ABA 403.3

As Built Meas:	35	Quantity:	LF
Description:	Cross slope exceeds 2.0% (5.0% or more)		
As Built Desc:	6.4% cross slope		
Solution:	Demolish existing and construct new route		
Bar. Severity:	1 Necessary	Cost Estimate:	\$4,375.00
Implementation Priority:	1	Facility Function:	
Implementation Phase:		Implementation Date:	
Official Responsible:

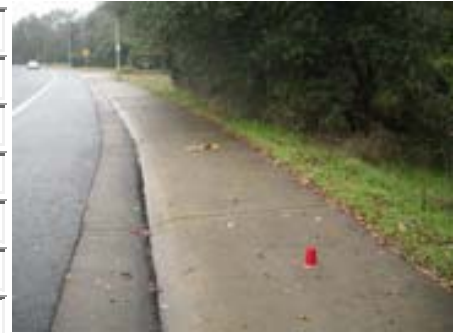
Field Date:	12/3/2010	Report Date:	12/3/2010	Barrier #:	3150
Location:	Van Maren Ln - East				
X Coordinate:	-121.30915				
Y Coordinate:	38.68363				
Barrier Area:	Sidewalks				
Barrier Type:	Cross Slope - Existing (5.0% or more)				
Code Ref:	CBC 1133B.7.1.3 and ADA/ABA 403.3

As Built Meas:	164	Quantity:	LF	
Description:	Cross slope exceeds 2.0% (5.0% or more)			
As Built Desc:	5.3% cross slope			
Solution:	Demolish existing and construct new route			
Bar. Severity:	1 Necessary	Cost Estimate:	\$20,500.00	Status:
Implementation Priority:	1	Facility Function:		
Implementation Phase:		Implementation Date:		
Official Responsible:

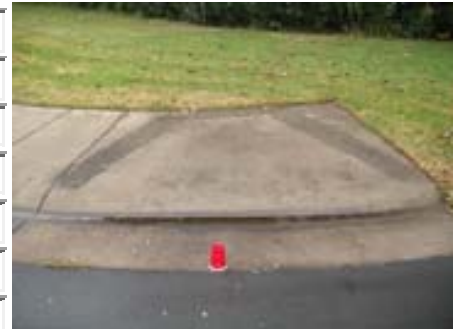
Field Date:	12/3/2010	Report Date:	12/3/2010	Barrier #:	3151A
Location:	Van Maren Ln and Christ the King Retreat Center Entrance - Corner B				
X Coordinate:	-121.3089				
Y Coordinate:	38.68424				
Barrier Area:	Curb Ramps				
Barrier Type:	12" Grooves - Existing (3.1% to 4.0%)				
Code Ref:	CBC 1127B.5.6

As Built Meas:	1	Quantity:	EACH	
Description:	12" grooves at top of curb ramp are not level (3.1% to 4.0%)			
As Built Desc:	3.6% at 12" grooves			
Solution:	Demolish existing and construct new curb ramp			
Bar. Severity:	3 Hindrance	Cost Estimate:	\$2,500.00	Status:
Implementation Priority:	1	Facility Function:		
Implementation Phase:		Implementation Date:		
Official Responsible:

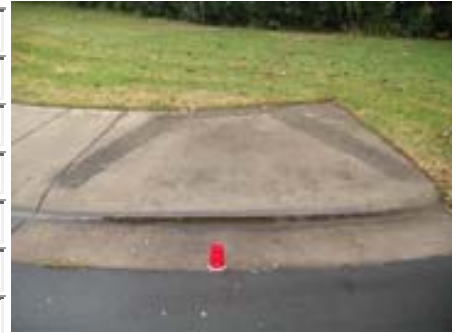
Field Date: 12/3/2010 Report Date: 12/3/2010 Barrier #: 3151B  
 Location: Van Maren Ln and Christ the King Retreat Center Entrance - Corner B  
 X Coordinate: -121.3089  
 Y Coordinate: 38.68424  
 Barrier Area: Curb Ramps  
 Barrier Type: Running Slope - Existing (9.5% or more)  
 Code Ref: CBC 1127B.5.3 and ADA/ABA 406.1

As Built Meas: 1 Quantity: EACH  
 Description: Ramp run cross slope exceeds 2.0% (9.5% or more)  
 As Built Desc: 10.6% running slope  
 Solution: Demolish existing and construct new curb ramp  
 Bar. Severity: 1 Necessary Cost Estimate: \$0.00 Status:   
 Implementation Priority: 1 Facility Function:   
 Implementation Phase: Implementation Date:   
 Official Responsible:

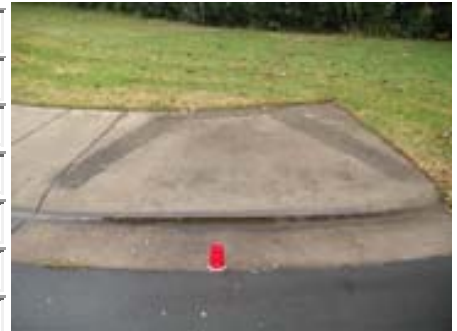
Field Date: 12/3/2010 Report Date: 12/3/2010 Barrier #: 3151C  
 Location: Van Maren Ln and Christ the King Retreat Center Entrance - Corner B  
 X Coordinate: -121.3089  
 Y Coordinate: 38.68424  
 Barrier Area: Curb Ramps  
 Barrier Type: Detectable Warnings - Truncated Domes  
 Code Ref: CBC 1127B.5.7 and ADA/ABA 705.1.3

As Built Meas: 1 Quantity: EACH  
 Description: No truncated domes provided at curb ramp  
 As Built Desc: No detectable warnings at curb ramp  
 Solution: Provide compliant truncated domes  
 Bar. Severity: 2 Recommended Cost Estimate: \$0.00 Status:   
 Implementation Priority: 1 Facility Function:   
 Implementation Phase: Implementation Date:   
 Official Responsible:

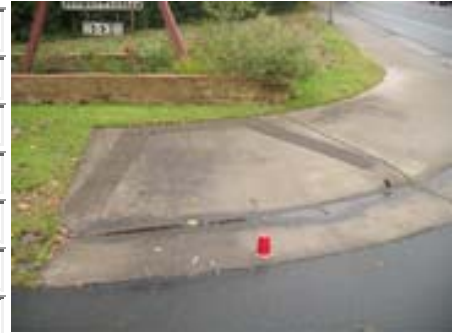
Field Date: 12/3/2010 Report Date: 12/3/2010 Barrier #: 3152A  
 Location: Van Maren Ln and Christ the King Retreat Center Entrance - Corner C  
 X Coordinate: -121.30896  
 Y Coordinate: 38.68409  
 Barrier Area: Curb Ramps  
 Barrier Type: Cross Slope - Existing (3.1% to 4.0%)  
 Code Ref: CBC 1127B.5.3 and ADA/ABA 406.2

As Built Meas: 1 Quantity: EACH  
 Description: Ramp run cross slope exceeds 2.0% (3.1% to 4.0%)  
 As Built Desc: 3.5% cross slope  
 Solution: Demolish existing and construct new curb ramp  
 Bar. Severity: 3 Hindrance Cost Estimate: \$2,500.00 Status:  
 Implementation Priority: 1 Facility Function:  
 Implementation Phase: Implementation Date:  
 Official Responsible:

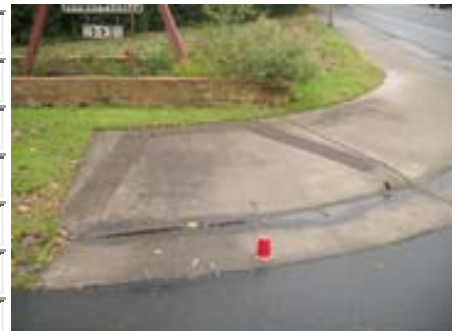
Field Date: 12/3/2010 Report Date: 12/3/2010 Barrier #: 3152B  
 Location: Van Maren Ln and Christ the King Retreat Center Entrance - Corner C  
 X Coordinate: -121.30896  
 Y Coordinate: 38.68409  
 Barrier Area: Curb Ramps  
 Barrier Type: Running Slope - Existing (9.5% or more)  
 Code Ref: CBC 1127B.5.3 and ADA/ABA 406.1

As Built Meas: 1 Quantity: EACH  
 Description: Ramp run cross slope exceeds 2.0% (9.5% or more)  
 As Built Desc: 12.6% running slope  
 Solution: Demolish existing and construct new curb ramp  
 Bar. Severity: 1 Necessary Cost Estimate: \$0.00 Status:  
 Implementation Priority: 1 Facility Function:  
 Implementation Phase: Implementation Date:  
 Official Responsible:

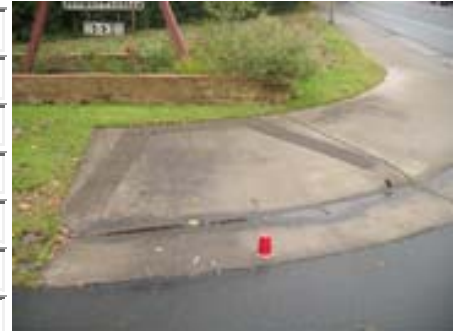
Field Date: 12/3/2010 Report Date: 12/3/2010 Barrier #: 3152C  
 Location: Van Maren Ln and Christ the King Retreat Center Entrance - Corner C  
 X Coordinate: -121.30896  
 Y Coordinate: 38.68409  
 Barrier Area: Curb Ramps  
 Barrier Type: Detectable Warnings - Truncated Domes  
 Code Ref: CBC 1127B.5.7 and ADA/ABA 705.1.3

As Built Meas: 1 Quantity: EACH  
 Description: No truncated domes provided at curb ramp  
 As Built Desc: No detectable warnings at curb ramp  
 Solution: Provide compliant truncated domes  
 Bar. Severity: 2 Recommended Cost Estimate: \$0.00 Status:   
 Implementation Priority: 1 Facility Function:   
 Implementation Phase: Implementation Date:   
 Official Responsible:

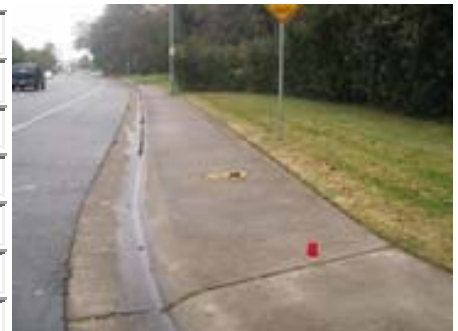
Field Date: 12/3/2010 Report Date: 12/3/2010 Barrier #: 3153  
 Location: Van Maren Ln - East  
 X Coordinate: -121.30892  
 Y Coordinate: 38.68425  
 Barrier Area: Sidewalks  
 Barrier Type: Cross Slope - Existing (5.0% or more)  
 Code Ref: CBC 1133B.7.1.3 and ADA/ABA 403.3

As Built Meas: 563 Quantity: LF  
 Description: Cross slope exceeds 2.0% (5.0% or more)  
 As Built Desc: 5.4% cross slope  
 Solution: Demolish existing and construct new route  
 Bar. Severity: 1 Necessary Cost Estimate: \$70,375.00 Status:   
 Implementation Priority: 1 Facility Function:   
 Implementation Phase: Implementation Date:   
 Official Responsible:

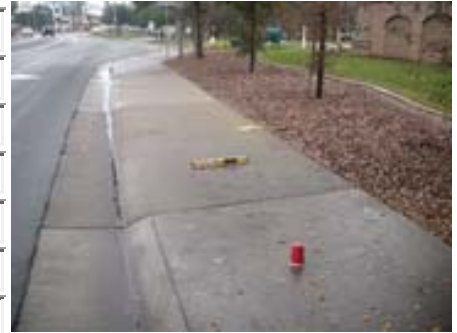
Field Date:	12/3/2010	Report Date:	12/3/2010	Barrier #:	3154
Location:	Van Maren Ln - East				
X Coordinate:	-121.30875				
Y Coordinate:	38.68595				
Barrier Area:	Sidewalks				
Barrier Type:	Cross Slope - Existing (3.1% to 4.0%)				
Code Ref:	CBC 1133B.7.1.3 and ADA/ABA 403.3

As Built Meas:	76	Quantity:	LF		
Description:	Cross slope exceeds 2.0% (3.1% to 4.0%)				
As Built Desc:	3.4% cross slope				
Solution:	Demolish existing and construct new route				
Bar. Severity:	3 Hinderance	Cost Estimate:	\$9,500.00	Status:	
Implementation Priority:	1	Facility Function:			
Implementation Phase:		Implementation Date:			
Official Responsible:

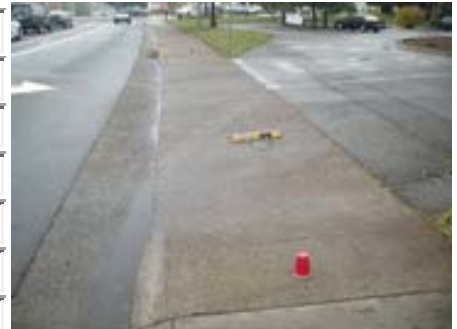
Field Date:	12/3/2010	Report Date:	12/3/2010	Barrier #:	3155
Location:	Van Maren Ln - East				
X Coordinate:	-121.30859				
Y Coordinate:	38.68643				
Barrier Area:	Sidewalks				
Barrier Type:	Driveway - Existing (5.0% or more)				
Code Ref:	CBC 1133B.7.1.3 and ADA/ABA 403.3

As Built Meas:	41	Quantity:	LF		
Description:	Driveway cross slope exceeds 2.0% (5.0% or more)				
As Built Desc:	7.8% cross slope				
Solution:	Provide min. 48" wide level walkway through driveway				
Bar. Severity:	4 Low Severity	Cost Estimate:	\$5,125.00	Status:	
Implementation Priority:	1	Facility Function:			
Implementation Phase:		Implementation Date:			
Official Responsible:

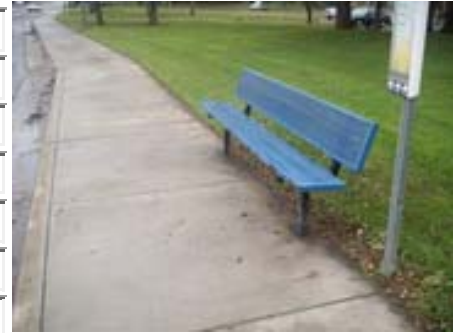
Field Date:	12/3/2010	Report Date:	12/3/2010	Barrier #:	3156A
Location:	Auburn Blvd - South				
X Coordinate:	-121.30818				
Y Coordinate:	38.6872				
Barrier Area:	Bus Stops and Shelters				
Barrier Type:	Bench Back Support				
Code Ref:	ADAAG 4.37.4 and ADA/ABA 903.4

As Built Meas:	1	Quantity:	EACH		
Description:	Bench has no back support of at least 18" high				
As Built Desc:	16" back support height				
Solution:	Provide min. 1 accessible bench at bench stop or shelter				
Bar. Severity:	3 Hindrance	Cost Estimate:	\$1,400.00	Status:	
Implementation Priority:	1	Facility Function:			
Implementation Phase:		Implementation Date:			
Official Responsible:

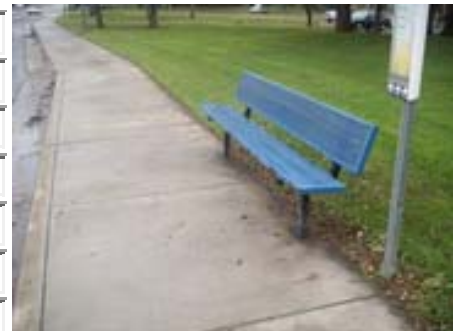
Field Date:	12/3/2010	Report Date:	12/3/2010	Barrier #:	3156B
Location:	Auburn Blvd - South				
X Coordinate:	-121.30818				
Y Coordinate:	38.6872				
Barrier Area:	Bus Stops and Shelters				
Barrier Type:	Bench Seat Depth				
Code Ref:	ADAAG 4.37.1 and ADA/ABA 903.4

As Built Meas:	1	Quantity:	EACH		
Description:	Bench seat depth not 20" - 24" deep				
As Built Desc:	12-1/2" bench seat depth				
Solution:	Provide min. 1 accessible bench at bench stop				
Bar. Severity:	3 Hindrance	Cost Estimate:	\$0.00	Status:	
Implementation Priority:	1	Facility Function:			
Implementation Phase:		Implementation Date:			
Official Responsible:

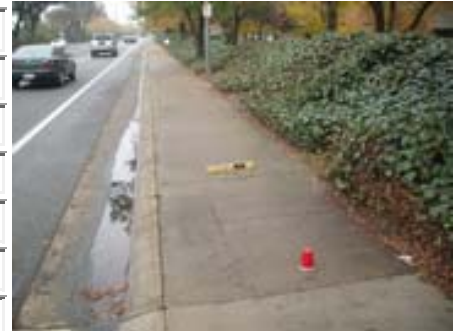
Field Date:	12/3/2010	Report Date:	12/3/2010	Barrier #:	3157A
Location:	Auburn Blvd - South				
X Coordinate:	-121.30724				
Y Coordinate:	38.68789				
Barrier Area:	Sidewalks				
Barrier Type:	Cross Slope - Existing (5.0% or more)				
Code Ref:	CBC 1133B.7.1.3 and ADA/ABA 403.3

As Built Meas:	351	Quantity:	LF		
Description:	Cross slope exceeds 2.0% (5.0% or more)				
As Built Desc:	6.0% cross slope				
Solution:	Demolish existing and construct new route				
Bar. Severity:	1 Necessary	Cost Estimate:	\$43,875.00	Status:	
Implementation Priority:	1	Facility Function:			
Implementation Phase:		Implementation Date:			
Official Responsible:

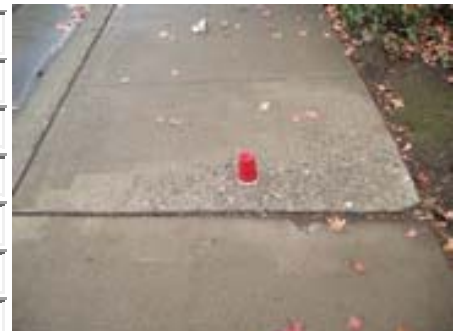
Field Date:	12/3/2010	Report Date:	12/3/2010	Barrier #:	3157B
Location:	Auburn Blvd - South				
X Coordinate:	-121.30686				
Y Coordinate:	38.68817				
Barrier Area:	Sidewalks				
Barrier Type:	Abrupt Change in Level - > 1/2"				
Code Ref:	CBC 1133B.7.1 and ADA/ABA 303.3

As Built Meas:	4	Quantity:	LF		
Description:	Change in level greater than 1/2"				
As Built Desc:	1" lip in sidewalk surface				
Solution:	Grind or repair sidewalk to remove trip hazard				
Bar. Severity:	1 Necessary	Cost Estimate:	\$1,000.00	Status:	
Implementation Priority:	1	Facility Function:			
Implementation Phase:		Implementation Date:			
Official Responsible:

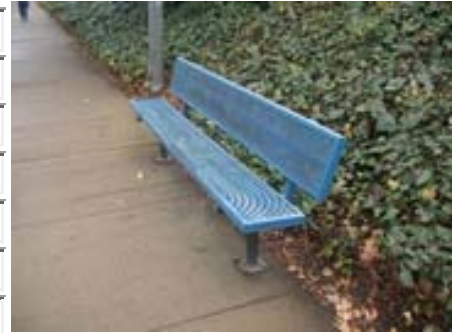
Field Date:	12/3/2010	Report Date:	12/3/2010	Barrier #:	3158A
Location:	Auburn Blvd - South				
X Coordinate:	-121.30629				
Y Coordinate:	38.6886				
Barrier Area:	Bus Stops and Shelters				
Barrier Type:	Bench Seat Depth				
Code Ref:	ADAAG 4.37.1 and ADA/ABA 903.4

As Built Meas:	1	Quantity:	EACH
Description:	Bench seat depth not 20" - 24" deep		
As Built Desc:	12-1/2" bench seat depth		
Solution:	Provide min. 1 accessible bench at bench stop		
Bar. Severity:	3 Hindrance	Cost Estimate:	\$775.00
Implementation Priority:	1	Facility Function:	
Implementation Phase:		Implementation Date:	
Official Responsible:

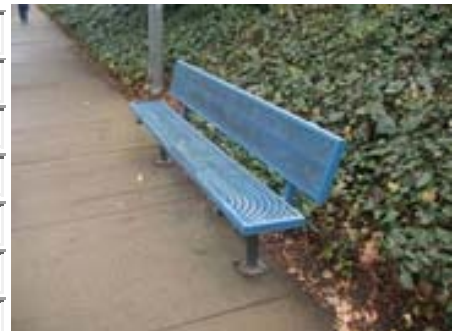
Field Date:	12/3/2010	Report Date:	12/3/2010	Barrier #:	3158B
Location:	Auburn Blvd - South				
X Coordinate:	-121.30629				
Y Coordinate:	38.6886				
Barrier Area:	Bus Stops and Shelters				
Barrier Type:	Bench Back Support				
Code Ref:	ADAAG 4.37.4 and ADA/ABA 903.4

As Built Meas:	1	Quantity:	EACH
Description:	Back support does not extend from 2" above seat to min. 18" above seat		
As Built Desc:	16" back support height		
Solution:	Provide min. 1 accessible bench at bench stop or shelter		
Bar. Severity:	3 Hindrance	Cost Estimate:	\$0.00
Implementation Priority:	1	Facility Function:	
Implementation Phase:		Implementation Date:	
Official Responsible:

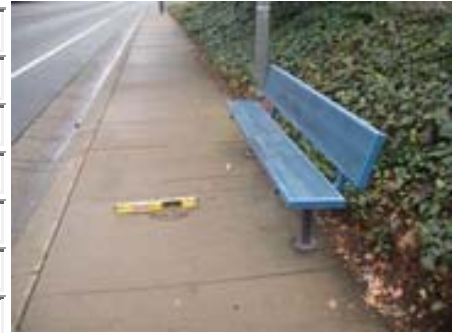
Field Date:	12/3/2010	Report Date:	12/3/2010	Barrier #:	3158C
Location:	Auburn Blvd - South				
X Coordinate:	-121.30629				
Y Coordinate:	38.6886				
Barrier Area:	Bus Stops and Shelters				
Barrier Type:	Cross Slope - Existing (3.1% to 4.0%)				
Code Ref:	CBC 1121B.2.1 and ADAAG 10.2.1(1)

As Built Meas:	10	Quantity:	LF		
Description:	Cross slope at bus pad or shelter exceeds 2.0% (3.1% to 4.0%)				
As Built Desc:	3.8% cross slope				
Solution:	Demolish existing and construct new bus pad or shelter pad				
Bar. Severity:	3 Hindrance	Cost Estimate:	\$1,250.00	Status:	
Implementation Priority:	1	Facility Function:			
Implementation Phase:		Implementation Date:			
Official Responsible:

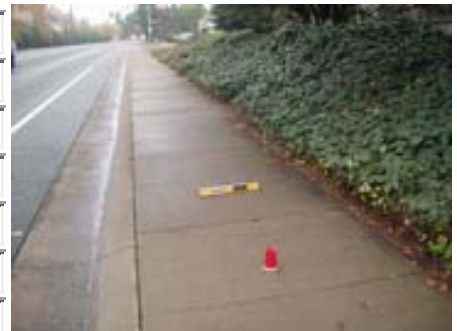
Field Date:	12/3/2010	Report Date:	12/3/2010	Barrier #:	3159
Location:	Auburn Blvd - South				
X Coordinate:	-121.30625				
Y Coordinate:	38.68861				
Barrier Area:	Sidewalks				
Barrier Type:	Cross Slope - Existing (5.0% or more)				
Code Ref:	CBC 1133B.7.1.3 and ADA/ABA 403.3

As Built Meas:	211	Quantity:	LF		
Description:	Cross slope exceeds 2.0% (5.0% or more)				
As Built Desc:	5.0% cross slope				
Solution:	Demolish existing and construct new route				
Bar. Severity:	1 Necessary	Cost Estimate:	\$26,375.00	Status:	
Implementation Priority:	1	Facility Function:			
Implementation Phase:		Implementation Date:			
Official Responsible:

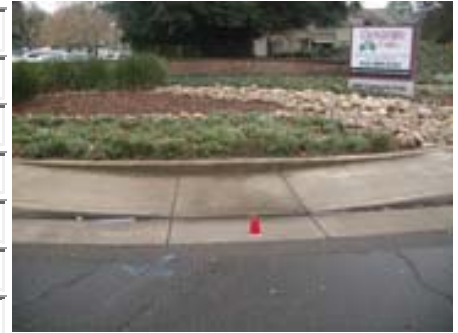
Field Date:	12/3/2010	Report Date:	12/3/2010	Barrier #:	3160A
Location:	Auburn Blvd and Crossroads Pkwy - Corner D				
X Coordinate:	-121.30562				
Y Coordinate:	38.68899				
Barrier Area:	Curb Ramps				
Barrier Type:	12" Grooves - Existing (3.1% to 4.0%)				
Code Ref:	CBC 1127B.5.6

As Built Meas:	1	Quantity:	EACH	
Description:	12" grooves at top of curb ramp are not level (3.1% to 4.0%)			
As Built Desc:	3.8% at 12" grooves			
Solution:	Demolish existing and construct new curb ramp			
Bar. Severity:	3 Hindrance	Cost Estimate:	\$2,500.00	Status:
Implementation Priority:	1	Facility Function:		
Implementation Phase:		Implementation Date:		
Official Responsible:

Notes: Two - way intersection corners C,D. Corner C compliant

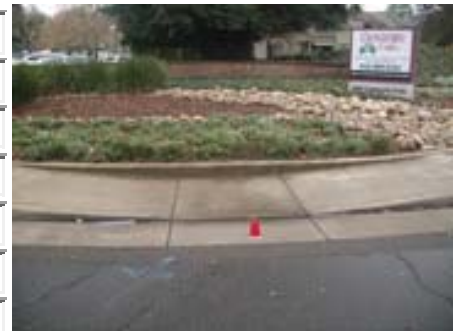
Field Date:	12/3/2010	Report Date:	12/3/2010	Barrier #:	3160B
Location:	Auburn Blvd and Crossroads Pkwy - Corner D				
X Coordinate:	-121.30562				
Y Coordinate:	38.68899				
Barrier Area:	Curb Ramps				
Barrier Type:	Detectable Warnings - Truncated Domes				
Code Ref:	CBC 1127B.5.7 and ADA/ABA 705.1.3

As Built Meas:	1	Quantity:	EACH	
Description:	No truncated domes provided at curb ramp			
As Built Desc:	No detectable warnings at curb ramp			
Solution:	Provide compliant truncated domes			
Bar. Severity:	2 Recommended	Cost Estimate:	\$0.00	Status:
Implementation Priority:	1	Facility Function:		
Implementation Phase:		Implementation Date:		
Official Responsible:

Notes: Two - way intersection corners C,D. Corner C compliant

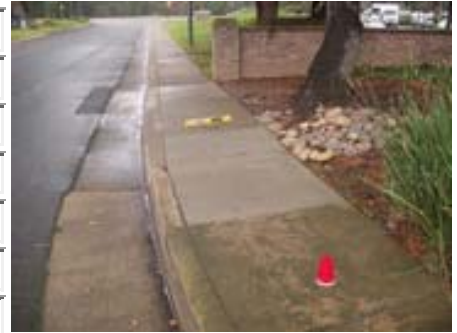
Field Date:	12/3/2010	Report Date:	12/3/2010	Barrier #:	3161
Location:	Crosswoods Pkwy - West				
X Coordinate:	-121.30554				
Y Coordinate:	38.68889				
Barrier Area:	Sidewalks				
Barrier Type:	Cross Slope - Existing (5.0% or more)				
Code Ref:	CBC 1133B.7.1.3 and ADA/ABA 403.3

As Built Meas:	28	Quantity:	LF	
Description:	Cross slope exceeds 2.0% (5.0% or more)			
As Built Desc:	7.8% cross slope			
Solution:	Demolish existing and construct new route			
Bar. Severity:	1 Necessary	Cost Estimate:	\$3,500.00	Status:
Implementation Priority:	2	Facility Function:		
Implementation Phase:		Implementation Date:		
Official Responsible:

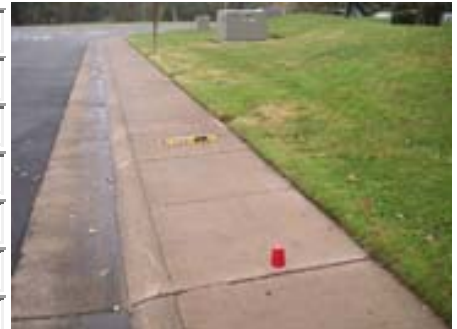
Field Date:	12/3/2010	Report Date:	12/3/2010	Barrier #:	3162
Location:	Crosswoods Pkwy - West				
X Coordinate:	-121.30531				
Y Coordinate:	38.68864				
Barrier Area:	Sidewalks				
Barrier Type:	Cross Slope - Existing (3.1% to 4.0%)				
Code Ref:	CBC 1133B.7.1.3 and ADA/ABA 403.3

As Built Meas:	50	Quantity:	LF	
Description:	Cross slope exceeds 2.0% (3.1% to 4.0%)			
As Built Desc:	3.9% cross slope			
Solution:	Demolish existing and construct new route			
Bar. Severity:	3 Hinderance	Cost Estimate:	\$6,250.00	Status:
Implementation Priority:	2	Facility Function:		
Implementation Phase:		Implementation Date:		
Official Responsible:

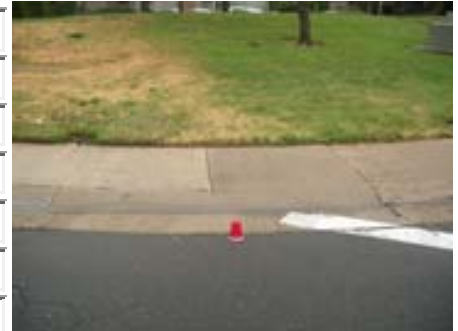
Field Date:	12/3/2010	Report Date:	12/3/2010	Barrier #:	3163
Location:	Crosswoods Pkwy and Crosswoods Cir - Corner A				
X Coordinate:	-121.30515				
Y Coordinate:	38.68833				
Barrier Area:	Curb Ramps				
Barrier Type:	No Curb Ramp				
Code Ref:	CBC 1127B.5.1 and ADA/ABA 402.2

As Built Meas:	1	Quantity:	EACH		
Description:	No curb cut at corner (intersection)				
As Built Desc:	No curb ramp at corner				
Solution:	Demolish existing and construct curb cut				
Bar. Severity:	1 Necessary	Cost Estimate:	\$2,500.00	Status:	
Implementation Priority:	2	Facility Function:			
Implementation Phase:		Implementation Date:			
Official Responsible:

Notes: Two - way intersection corners A,B

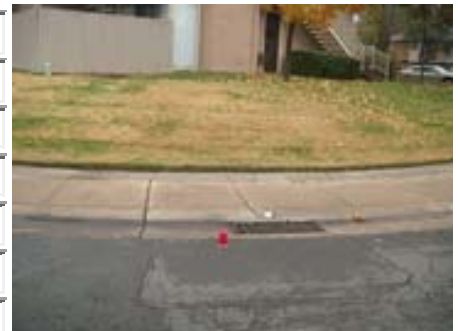
Field Date:	12/3/2010	Report Date:	12/3/2010	Barrier #:	3164
Location:	Crosswoods Pkwy and Crosswoods Cir - Corner B				
X Coordinate:	-121.30486				
Y Coordinate:	38.68849				
Barrier Area:	Curb Ramps				
Barrier Type:	No Curb Ramp				
Code Ref:	CBC 1127B.5.1 and ADA/ABA 402.2

As Built Meas:	1	Quantity:	EACH		
Description:	No curb cut at corner (intersection)				
As Built Desc:	No curb ramp at corner				
Solution:	Demolish existing and construct curb cut				
Bar. Severity:	1 Necessary	Cost Estimate:	\$2,500.00	Status:	
Implementation Priority:	2	Facility Function:			
Implementation Phase:		Implementation Date:			
Official Responsible:

Notes: Two - way intersection corners A,B

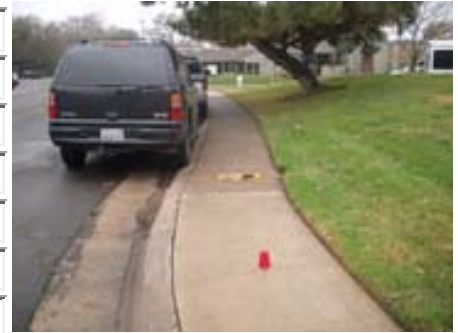
Field Date:	12/3/2010	Report Date:	12/3/2010	Barrier #:	3165
Location:	Crosswoods Cir - North				
X Coordinate:	-121.30516				
Y Coordinate:	38.68829				
Barrier Area:	Sidewalks				
Barrier Type:	Cross Slope - Existing (3.1% to 4.0%)				
Code Ref:	CBC 1133B.7.1.3 and ADA/ABA 403.3

As Built Meas:	91	Quantity:	LF		
Description:	Cross slope exceeds 2.0% (3.1% to 4.0%)				
As Built Desc:	3.9% cross slope				
Solution:	Demolish existing and construct new route				
Bar. Severity:	3 Hinderance	Cost Estimate:	\$11,375.00	Status:	
Implementation Priority:	2	Facility Function:			
Implementation Phase:		Implementation Date:			
Official Responsible:

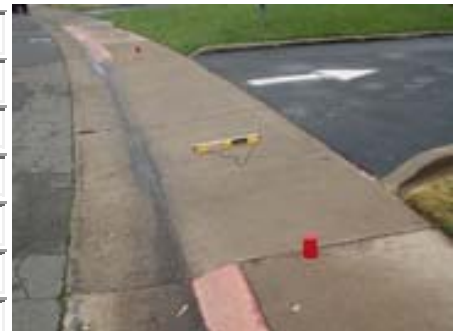
Field Date:	12/3/2010	Report Date:	12/3/2010	Barrier #:	3166
Location:	Crosswoods Cir - North				
X Coordinate:	-121.30543				
Y Coordinate:	38.68811				
Barrier Area:	Sidewalks				
Barrier Type:	Driveway - Existing (5.0% or more)				
Code Ref:	CBC 1133B.7.1.3 and ADA/ABA 403.3

As Built Meas:	25	Quantity:	LF		
Description:	Driveway cross slope exceeds 2.0% (5.0% or more)				
As Built Desc:	7.7% cross slope, 11.0% running slope				
Solution:	Provide min. 48" wide level walkway through driveway				
Bar. Severity:	1 Necessary	Cost Estimate:	\$3,125.00	Status:	
Implementation Priority:	2	Facility Function:			
Implementation Phase:		Implementation Date:			
Official Responsible:

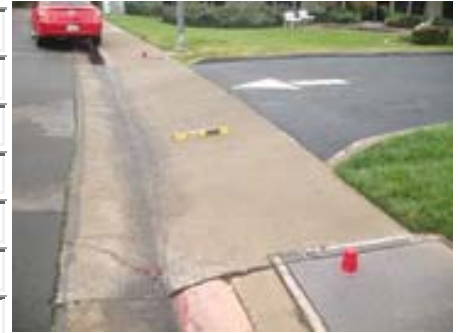
Field Date:	12/3/2010	Report Date:	12/3/2010	Barrier #:	3167
Location:	Crosswoods Cir - North				
X Coordinate:	-121.30552				
Y Coordinate:	38.68797				
Barrier Area:	Sidewalks				
Barrier Type:	Driveway - Existing (5.0% or more)				
Code Ref:	CBC 1133B.7.1.3 and ADA/ABA 403.3

As Built Meas:	28	Quantity:	LF		
Description:	Driveway cross slope exceeds 2.0% (5.0% or more)				
As Built Desc:	8.6% cross slope, 9.9% running slope				
Solution:	Provide min. 48" wide level walkway through driveway				
Bar. Severity:	1 Necessary	Cost Estimate:	\$3,500.00	Status:	
Implementation Priority:	2	Facility Function:			
Implementation Phase:		Implementation Date:			
Official Responsible:

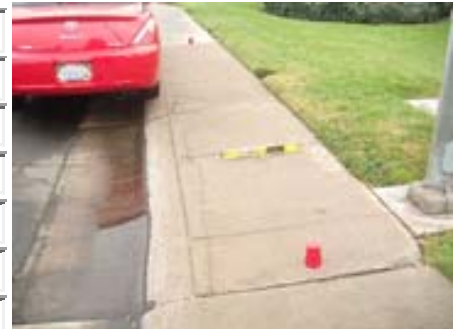
Field Date:	12/3/2010	Report Date:	12/3/2010	Barrier #:	3168
Location:	Crosswoods Cir - North				
X Coordinate:	-121.30557				
Y Coordinate:	38.68791				
Barrier Area:	Sidewalks				
Barrier Type:	Cross Slope - Existing (5.0% or more)				
Code Ref:	CBC 1133B.7.1.3 and ADA/ABA 403.3

As Built Meas:	25	Quantity:	LF		
Description:	Cross slope exceeds 2.0% (5.0% or more)				
As Built Desc:	5.6% cross slope				
Solution:	Demolish existing and construct new route				
Bar. Severity:	1 Necessary	Cost Estimate:	\$3,125.00	Status:	
Implementation Priority:	2	Facility Function:			
Implementation Phase:		Implementation Date:			
Official Responsible:

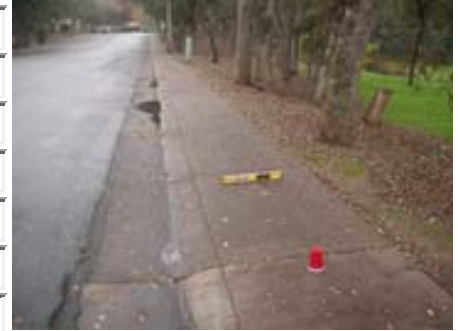
Field Date:	12/3/2010	Report Date:	12/3/2010	Barrier #:	3169
Location:	Crosswoods Cir - West				
X Coordinate:	-121.30552				
Y Coordinate:	38.687				
Barrier Area:	Sidewalks				
Barrier Type:	Cross Slope - Existing (4.1% to 4.9%)				
Code Ref:	CBC 1133B.7.1.3 and ADA/ABA 403.3

As Built Meas:	47	Quantity:	LF	
Description:	Cross slope exceeds 2.0% (4.1% to 4.9%)			
As Built Desc:	4.6% cross slope			
Solution:	Demolish existing and construct new route			
Bar. Severity:	2 Recommended	Cost Estimate:	\$5,875.00	Status:
Implementation Priority:	2	Facility Function:		
Implementation Phase:		Implementation Date:		
Official Responsible:

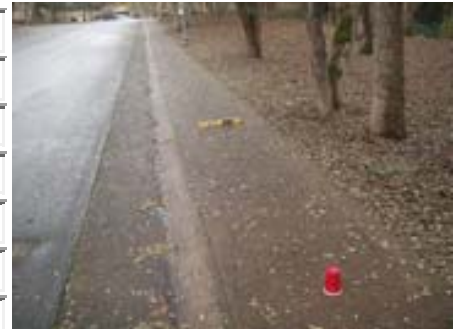
Field Date:	12/3/2010	Report Date:	12/3/2010	Barrier #:	3170
Location:	Crosswoods Cir - North				
X Coordinate:	-121.30517				
Y Coordinate:	38.68665				
Barrier Area:	Sidewalks				
Barrier Type:	Cross Slope - Existing (4.1% to 4.9%)				
Code Ref:	CBC 1133B.7.1.3 and ADA/ABA 403.3

As Built Meas:	350	Quantity:	LF	
Description:	Cross slope exceeds 2.0% (4.1% to 4.9%)			
As Built Desc:	4.5% cross slope			
Solution:	Demolish existing and construct new route			
Bar. Severity:	2 Recommended	Cost Estimate:	\$43,750.00	Status:
Implementation Priority:	2	Facility Function:		
Implementation Phase:		Implementation Date:		
Official Responsible:

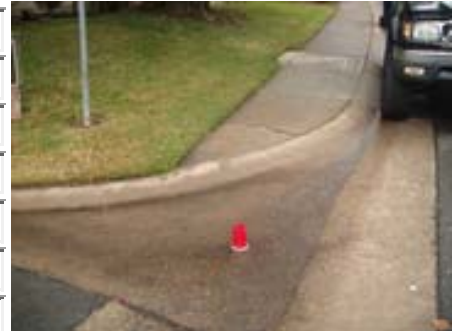
Field Date:	12/3/2010	Report Date:	12/3/2010	Barrier #:	3171
Location:	Crosswoods Cir and Castillo Ct - Corner A				
X Coordinate:	-121.30471				
Y Coordinate:	38.68538				
Barrier Area:	Curb Ramps				
Barrier Type:	No Curb Ramp				
Code Ref:	CBC 1127B.5.1 and ADA/ABA 402.2

As Built Meas:	1	Quantity:	EACH	
Description:	No curb cut at corner (intersection)			
As Built Desc:	No curb ramp at corner			
Solution:	Demolish existing and construct curb cut			
Bar. Severity:	1 Necessary	Cost Estimate:	\$2,500.00	Status:
Implementation Priority:	2	Facility Function:		
Implementation Phase:		Implementation Date:		
Official Responsible:

Notes: Two - way intersection corners A,D

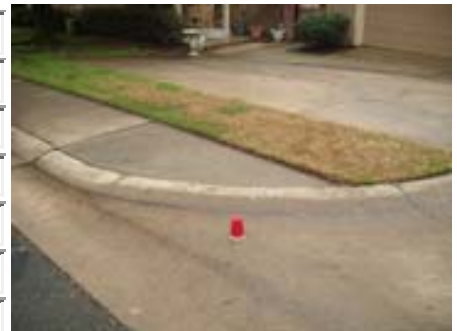
Field Date:	12/3/2010	Report Date:	12/3/2010	Barrier #:	3172
Location:	Crosswoods Cir and Castillo Ct - Corner D				
X Coordinate:	-121.30469				
Y Coordinate:	38.6853				
Barrier Area:	Curb Ramps				
Barrier Type:	No Curb Ramp				
Code Ref:	CBC 1127B.5.1 and ADA/ABA 402.2

As Built Meas:	1	Quantity:	EACH	
Description:	No curb cut at corner (intersection)			
As Built Desc:	No curb ramp at corner			
Solution:	Demolish existing and construct curb cut			
Bar. Severity:	1 Necessary	Cost Estimate:	\$2,500.00	Status:
Implementation Priority:	2	Facility Function:		
Implementation Phase:		Implementation Date:		
Official Responsible:

Notes: Two - way intersection corners A,D
