**DRAFT ADA TRANSITION PLAN UPDATE  
NEIGHBORHOOD AREA 4 ARCADE CREEK  
SEPTEMBER 20, 2011**

CITY OF CITRUS HEIGHTS

## Arcade Creek Neighborhood Area

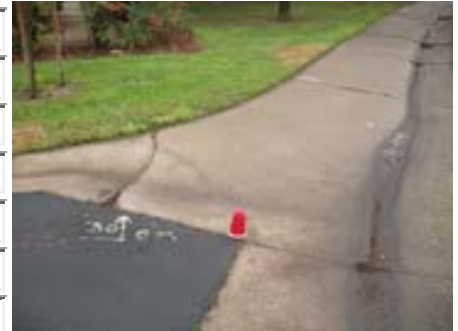
Field Date:	12/3/2010	Report Date:	12/3/2010	Barrier #:	3173
Location:	Crosswoods Cir and Crosswoods Ct - Corner A				
X Coordinate:	-121.30481				
Y Coordinate:	38.68481				
Barrier Area:	Curb Ramps				
Barrier Type:	No Curb Ramp				
Code Ref:	CBC 1127B.5.1 and ADA/ABA 402.2

As Built Meas:	1	Quantity:	EACH		
Description:	No curb cut at corner (intersection)				
As Built Desc:	No curb ramp at corner				
Solution:	Demolish existing and construct curb cut				
Bar. Severity:	1 Necessary	Cost Estimate:	\$2,500.00	Status:	
Implementation Priority:	2	Facility Function:			
Implementation Phase:		Implementation Date:			
Official Responsible:

Notes: Two - way intersection corners A,D

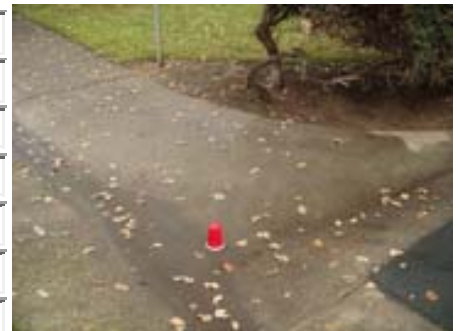
Field Date:	12/3/2010	Report Date:	12/3/2010	Barrier #:	3174
Location:	Crosswoods Cir and Crosswoods Ct - Corner D				
X Coordinate:	-121.30482				
Y Coordinate:	38.68475				
Barrier Area:	Curb Ramps				
Barrier Type:	No Curb Ramp				
Code Ref:	CBC 1127B.5.1 and ADA/ABA 402.2

As Built Meas:	1	Quantity:	EACH		
Description:	No curb cut at corner (intersection)				
As Built Desc:	No curb ramp at corner				
Solution:	Demolish existing and construct curb cut				
Bar. Severity:	1 Necessary	Cost Estimate:	\$2,500.00	Status:	
Implementation Priority:	2	Facility Function:			
Implementation Phase:		Implementation Date:			
Official Responsible:

Notes: Two - way intersection corners A,D

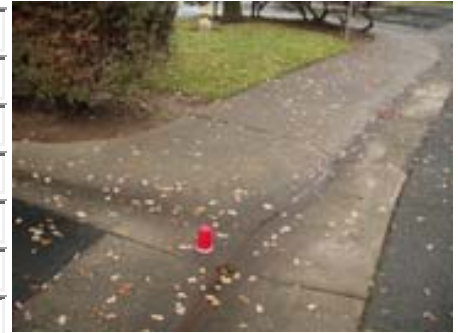
Field Date:	12/3/2010	Report Date:	12/3/2010	Barrier #:	3175
Location:	Crosswoods Cir and Crosswoods Ct - Corner A				
X Coordinate:	-121.30482				
Y Coordinate:	38.68463				
Barrier Area:	Curb Ramps				
Barrier Type:	No Curb Ramp				
Code Ref:	CBC 1127B.5.1 and ADA/ABA 402.2

As Built Meas:	1	Quantity:	EACH	
Description:	No curb cut at corner (intersection)			
As Built Desc:	No curb ramp at corner			
Solution:	Demolish existing and construct curb cut			
Bar. Severity:	1 Necessary	Cost Estimate:	\$2,500.00	Status:
Implementation Priority:	2	Facility Function:		
Implementation Phase:		Implementation Date:		
Official Responsible:

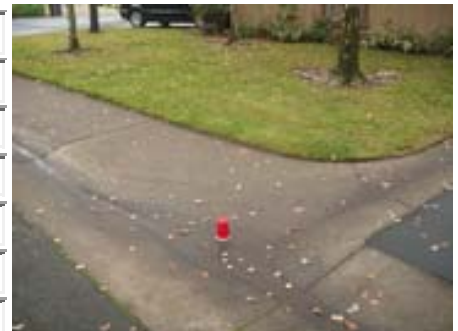
Field Date:	12/3/2010	Report Date:	12/3/2010	Barrier #:	3176
Location:	Crosswoods Cir and Crosswoods Ct - Corner D				
X Coordinate:	-121.30478				
Y Coordinate:	38.68454				
Barrier Area:	Curb Ramps				
Barrier Type:	No Curb Ramp				
Code Ref:	CBC 1127B.5.1 and ADA/ABA 402.2

As Built Meas:	1	Quantity:	EACH	
Description:	No curb cut at corner (intersection)			
As Built Desc:	No curb ramp at corner			
Solution:	Demolish existing and construct curb cut			
Bar. Severity:	1 Necessary	Cost Estimate:	\$2,500.00	Status:
Implementation Priority:	2	Facility Function:		
Implementation Phase:		Implementation Date:		
Official Responsible:

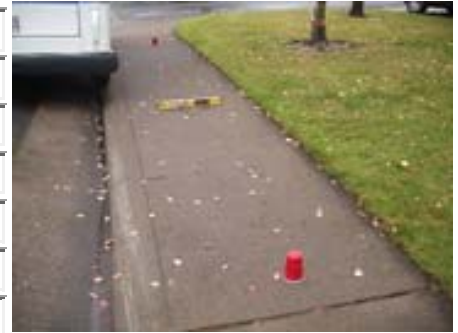
Field Date:	12/3/2010	Report Date:	12/3/2010	Barrier #:	3177
Location:	Crosswoods Cir - West				
X Coordinate:	-121.30477				
Y Coordinate:	38.68448				
Barrier Area:	Sidewalks				
Barrier Type:	Cross Slope - Existing (3.1% to 4.0%)				
Code Ref:	CBC 1133B.7.1.3 and ADA/ABA 403.3

As Built Meas:	21	Quantity:	LF		
Description:	Cross slope exceeds 2.0% (3.1% to 4.0%)				
As Built Desc:	3.8% cross slope				
Solution:	Demolish existing and construct new route				
Bar. Severity:	3 Hinderance	Cost Estimate:	\$2,625.00	Status:	
Implementation Priority:	2	Facility Function:			
Implementation Phase:		Implementation Date:			
Official Responsible:

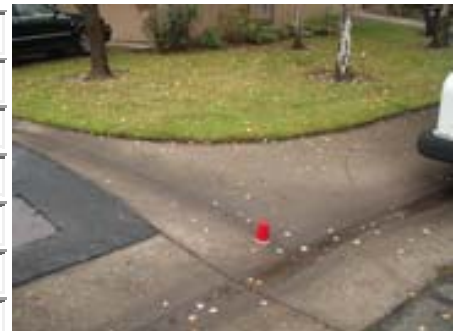
Field Date:	12/3/2010	Report Date:	12/3/2010	Barrier #:	3178
Location:	Crosswoods Cir and San Dimas Ct - Corner A				
X Coordinate:	-121.30472				
Y Coordinate:	38.68444				
Barrier Area:	Curb Ramps				
Barrier Type:	No Curb Ramp				
Code Ref:	CBC 1127B.5.1 and ADA/ABA 402.2

As Built Meas:	1	Quantity:	EACH		
Description:	No curb cut at corner (intersection)				
As Built Desc:	No curb ramp at corner				
Solution:	Demolish existing and construct curb cut				
Bar. Severity:	1 Necessary	Cost Estimate:	\$2,500.00	Status:	
Implementation Priority:	2	Facility Function:			
Implementation Phase:		Implementation Date:			
Official Responsible:

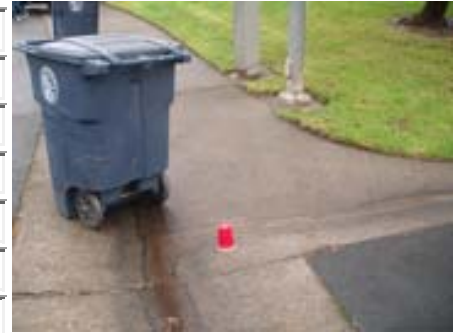
Field Date:	12/3/2010	Report Date:	12/3/2010	Barrier #:	3179
Location:	Crosswoods Cir and San Dimas Ct - Corner D				
X Coordinate:	-121.30465				
Y Coordinate:	38.68436				
Barrier Area:	Curb Ramps				
Barrier Type:	No Curb Ramp				
Code Ref:	CBC 1127B.5.1 and ADA/ABA 402.2

As Built Meas:	1	Quantity:	EACH		
Description:	No curb cut at corner (intersection)				
As Built Desc:	No curb ramp at corner				
Solution:	Demolish existing and construct curb cut				
Bar. Severity:	1 Necessary	Cost Estimate:	\$2,500.00	Status:	
Implementation Priority:	2	Facility Function:			
Implementation Phase:		Implementation Date:			
Official Responsible:

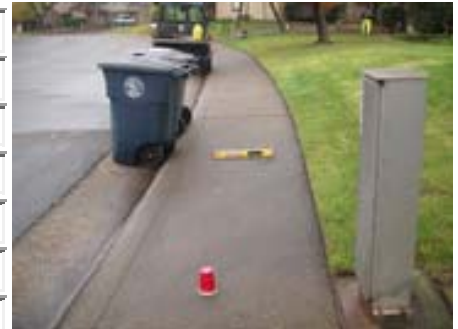
Field Date:	12/3/2010	Report Date:	12/3/2010	Barrier #:	3180
Location:	Crosswoods Cir - West				
X Coordinate:	-121.30461				
Y Coordinate:	38.68431				
Barrier Area:	Sidewalks				
Barrier Type:	Cross Slope - Existing (4.1% to 4.9%)				
Code Ref:	CBC 1133B.7.1.3 and ADA/ABA 403.3

As Built Meas:	91	Quantity:	LF		
Description:	Cross slope exceeds 2.0% (4.1% to 4.9%)				
As Built Desc:	4.7% cross slope				
Solution:	Demolish existing and construct new route				
Bar. Severity:	2 Recommended	Cost Estimate:	\$11,375.00	Status:	
Implementation Priority:	2	Facility Function:			
Implementation Phase:		Implementation Date:			
Official Responsible:

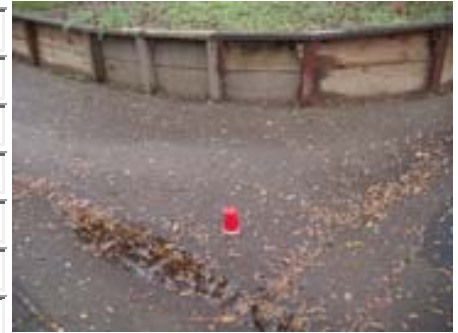
Barrier Type: No Curb Ramp

Code Ref: CBC 1127B.5.1 and ADA/ABA 402.2

As Built Meas: 1 Quantity: EACH

Description: No curb cut at corner (intersection)

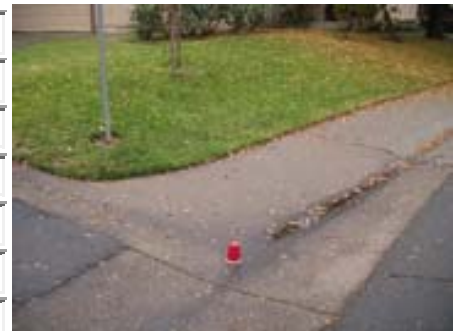
Barrier Type: No Curb Ramp

Code Ref: CBC 1127B.5.1 and ADA/ABA 402.2

As Built Meas: 1 Quantity: EACH

Description: No curb cut at corner (intersection)

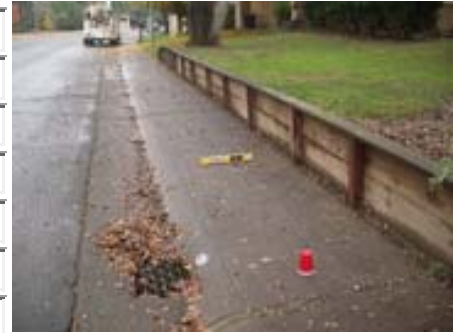
Field Date:	12/3/2010	Report Date:	12/3/2010	Barrier #:	3183
Location:	Crosswoods Cir - West				
X Coordinate:	-121.30379				
Y Coordinate:	38.68411				
Barrier Area:	Sidewalks				
Barrier Type:	Cross Slope - Existing (5.0% or more)				
Code Ref:	CBC 1133B.7.1.3 and ADA/ABA 403.3

As Built Meas:	300	Quantity:	LF	
Description:	Cross slope exceeds 2.0% (5.0% or more)			
As Built Desc:	5.4% cross slope			
Solution:	Demolish existing and construct new route			
Bar. Severity:	1 Necessary	Cost Estimate:	\$37,500.00	Status:
Implementation Priority:	2	Facility Function:		
Implementation Phase:		Implementation Date:		
Official Responsible:

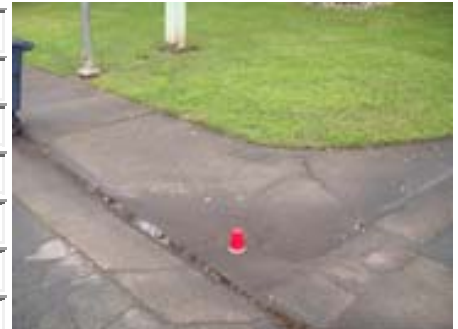
Field Date:	12/3/2010	Report Date:	12/3/2010	Barrier #:	3184
Location:	Crosswoods Cir and Monteverde Ln - Corner C				
X Coordinate:	-121.30269				
Y Coordinate:	38.68381				
Barrier Area:	Curb Ramps				
Barrier Type:	No Curb Ramp				
Code Ref:	CBC 1127B.5.1 and ADA/ABA 402.2

As Built Meas:	1	Quantity:	EACH	
Description:	No curb cut at corner (intersection)			
As Built Desc:	No curb ramp at corner			
Solution:	Demolish existing and construct curb cut			
Bar. Severity:	1 Necessary	Cost Estimate:	\$2,500.00	Status:
Implementation Priority:	2	Facility Function:		
Implementation Phase:		Implementation Date:		
Official Responsible:

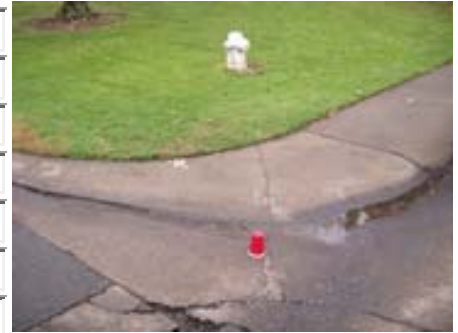
Field Date:	12/3/2010	Report Date:	12/3/2010	Barrier #:	3185
Location:	Crosswoods Cir and Monteverde Ln - Corner D				
X Coordinate:	-121.30279				
Y Coordinate:	38.68383				
Barrier Area:	Curb Ramps				
Barrier Type:	No Curb Ramp				
Code Ref:	CBC 1127B.5.1 and ADA/ABA 402.2

As Built Meas:	1	Quantity:	EACH
Description:	No curb cut at corner (intersection)		
As Built Desc:	No curb ramp at corner		
Solution:	Demolish existing and construct curb cut		
Bar. Severity:	1 Necessary	Cost Estimate:	\$2,500.00
Implementation Priority:	2	Facility Function:	
Implementation Phase:		Implementation Date:	
Official Responsible:

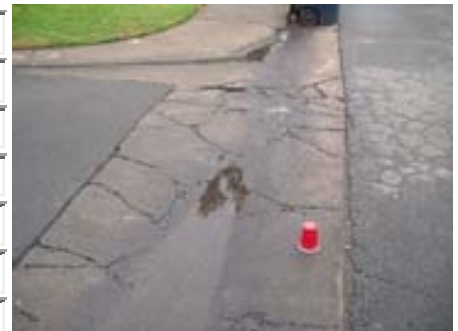
Field Date:	12/3/2010	Report Date:	12/3/2010	Barrier #:	3186
Location:	Crosswoods Cir - West				
X Coordinate:	-121.30276				
Y Coordinate:	38.68382				
Barrier Area:	Sidewalks				
Barrier Type:	Surface Condition - Damaged				
Code Ref:	CBC 1133B.7.1 and ADA/ABA 302.1

As Built Meas:	24	Quantity:	LF
Description:	Surface is not firm and stable (cracked, broken or loose soil, etc.)		
As Built Desc:	Crosswalk concrete in very poor condition		
Solution:	Repair surface to make firm and stable		
Bar. Severity:	1 Necessary	Cost Estimate:	\$3,000.00
Implementation Priority:	2	Facility Function:	
Implementation Phase:		Implementation Date:	
Official Responsible:

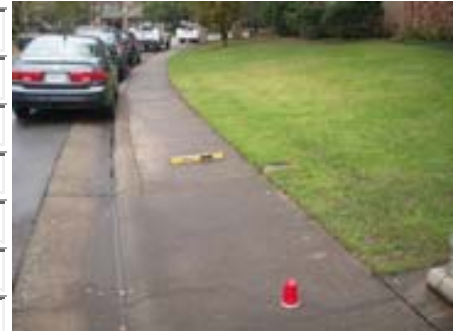
Field Date:	12/3/2010	Report Date:	12/3/2010	Barrier #:	3187
Location:	Crosswoods Cir - West				
X Coordinate:	-121.3026				
Y Coordinate:	38.68377				
Barrier Area:	Sidewalks				
Barrier Type:	Cross Slope - Existing (5.0% or more)				
Code Ref:	CBC 1133B.7.1.3 and ADA/ABA 403.3

As Built Meas:	370	Quantity:	LF		
Description:	Cross slope exceeds 2.0% (5.0% or more)				
As Built Desc:	5.5% cross slope				
Solution:	Demolish existing and construct new route				
Bar. Severity:	1 Necessary	Cost Estimate:	\$46,250.00	Status:	
Implementation Priority:	2	Facility Function:			
Implementation Phase:		Implementation Date:			
Official Responsible:

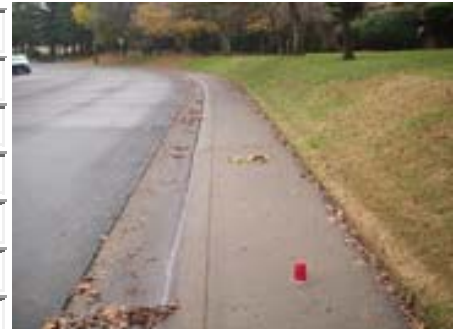
Field Date:	12/3/2010	Report Date:	12/3/2010	Barrier #:	3188
Location:	Crosswoods Cir - East				
X Coordinate:	-121.30208				
Y Coordinate:	38.6827				
Barrier Area:	Sidewalks				
Barrier Type:	Cross Slope - Existing (5.0% or more)				
Code Ref:	CBC 1133B.7.1.3 and ADA/ABA 403.3

As Built Meas:	370	Quantity:	LF		
Description:	Cross slope exceeds 2.0% (5.0% or more)				
As Built Desc:	5.5% cross slope				
Solution:	Demolish existing and construct new route				
Bar. Severity:	1 Necessary	Cost Estimate:	\$46,250.00	Status:	
Implementation Priority:	2	Facility Function:			
Implementation Phase:		Implementation Date:			
Official Responsible:

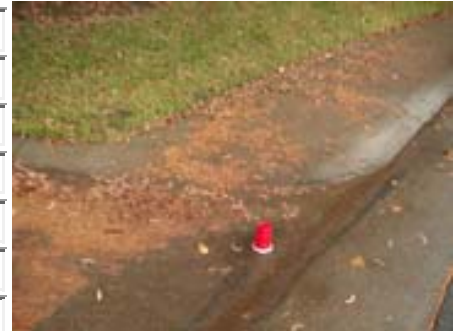
Barrier Type: No Curb Ramp - Depressed Existing Curb

Code Ref: CBC 1127B.5.1 and ADA/ABA 402.2

As Built Meas: 1 Quantity: EACH

Description: No compliant curb cut at corner (intersection)

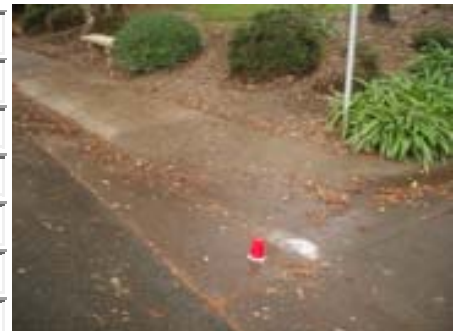
Barrier Type: No Curb Ramp - Depressed Existing Curb

Code Ref: CBC 1127B.5.1 and ADA/ABA 402.2

As Built Meas: 1 Quantity: EACH

Description: No compliant curb cut at corner (intersection)

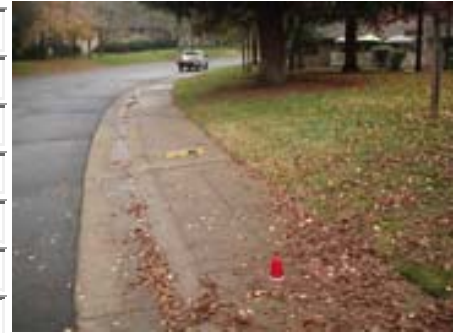
Field Date:	12/3/2010	Report Date:	12/3/2010	Barrier #:	3191
Location:	Crosswoods Cir - East				
X Coordinate:	-121.30159				
Y Coordinate:	38.68195				
Barrier Area:	Sidewalks				
Barrier Type:	Cross Slope - Existing (5.0% or more)				
Code Ref:	CBC 1133B.7.1.3 and ADA/ABA 403.3

As Built Meas:	211	Quantity:	LF	
Description:	Cross slope exceeds 2.0% (5.0% or more)			
As Built Desc:	5.9% cross slope			
Solution:	Demolish existing and construct new route			
Bar. Severity:	1 Necessary	Cost Estimate:	\$26,375.00	Status:
Implementation Priority:	2	Facility Function:		
Implementation Phase:		Implementation Date:		
Official Responsible:

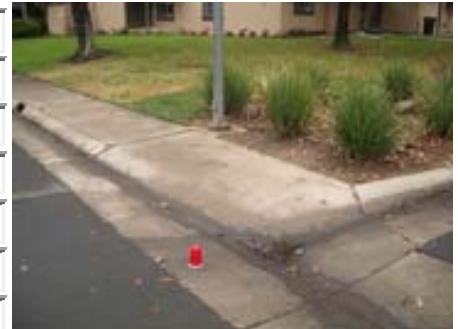
Field Date:	12/3/2010	Report Date:	12/3/2010	Barrier #:	3192
Location:	Crosswoods Cir and Crosswoods Cir - Corner B				
X Coordinate:	-121.30189				
Y Coordinate:	38.68268				
Barrier Area:	Curb Ramps				
Barrier Type:	No Curb Ramp - Depressed Existing Curb				
Code Ref:	CBC 1127B.5.1 and ADA/ABA 402.2

As Built Meas:	1	Quantity:	EACH	
Description:	No compliant curb cut at corner (intersection)			
As Built Desc:	7.7% running slope at depressed area			
Solution:	Demolish existing and construct curb cut			
Bar. Severity:	1 Necessary	Cost Estimate:	\$2,500.00	Status:
Implementation Priority:	2	Facility Function:		
Implementation Phase:		Implementation Date:		
Official Responsible:

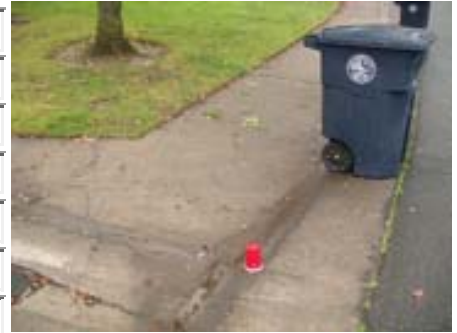
Field Date:	12/3/2010	Report Date:	12/3/2010	Barrier #:	3193
Location:	Crosswoods Cir and Crosswoods Cir - Corner C				
X Coordinate:	-121.30188				
Y Coordinate:	38.68263				
Barrier Area:	Curb Ramps				
Barrier Type:	No Curb Ramp - Depressed Existing Curb				
Code Ref:	CBC 1127B.5.1 and ADA/ABA 402.2

As Built Meas:	1	Quantity:	EACH
Description:	No compliant curb cut at corner (intersection)		
As Built Desc:	12.0% running slope at depressed area		
Solution:	Demolish existing and construct curb cut		
Bar. Severity:	1 Necessary	Cost Estimate:	\$2,500.00
Implementation Priority:	2	Facility Function:	
Implementation Phase:		Implementation Date:	
Official Responsible:

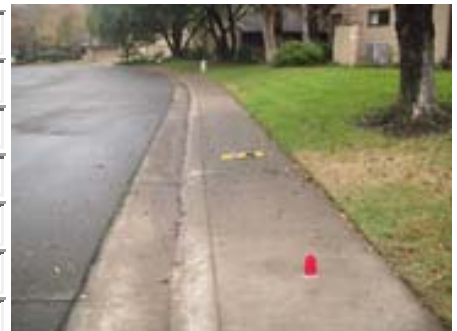
Field Date:	12/3/2010	Report Date:	12/3/2010	Barrier #:	3194
Location:	Crosswoods Cir - East				
X Coordinate:	-121.30186				
Y Coordinate:	38.68285				
Barrier Area:	Sidewalks				
Barrier Type:	Cross Slope - Existing (5.0% or more)				
Code Ref:	CBC 1133B.7.1.3 and ADA/ABA 403.3

As Built Meas:	220	Quantity:	LF
Description:	Cross slope exceeds 2.0% (5.0% or more)		
As Built Desc:	6.6% cross slope		
Solution:	Demolish existing and construct new route		
Bar. Severity:	1 Necessary	Cost Estimate:	\$27,500.00
Implementation Priority:	2	Facility Function:	
Implementation Phase:		Implementation Date:	
Official Responsible:

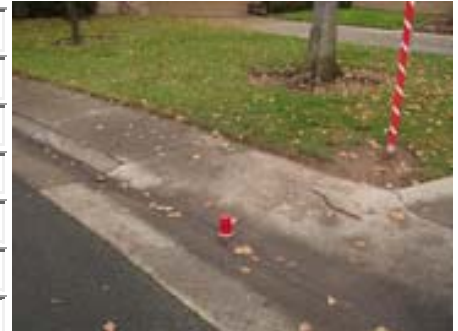
Field Date:	12/3/2010	Report Date:	12/3/2010	Barrier #:	3195
Location:	Crosswoods Cir and Crosswoods Ct - Corner B				
X Coordinate:	-121.30199				
Y Coordinate:	38.68333				
Barrier Area:	Curb Ramps				
Barrier Type:	No Curb Ramp - Depressed Existing Curb				
Code Ref:	CBC 1127B.5.1 and ADA/ABA 402.2

As Built Meas:	1	Quantity:	EACH	
Description:	No compliant curb cut at corner (intersection)			
As Built Desc:	6.2% running slope at depressed area			
Solution:	Demolish existing and construct curb cut			
Bar. Severity:	1 Necessary	Cost Estimate:	\$2,500.00	Status:
Implementation Priority:	2	Facility Function:		
Implementation Phase:		Implementation Date:		
Official Responsible:

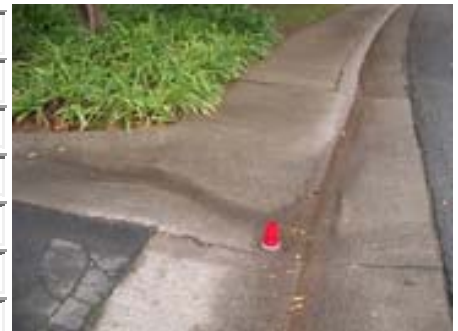
Field Date:	12/3/2010	Report Date:	12/3/2010	Barrier #:	3196
Location:	Crosswoods Cir and Crosswoods Ct - Corner C				
X Coordinate:	-121.30193				
Y Coordinate:	38.68325				
Barrier Area:	Curb Ramps				
Barrier Type:	No Curb Ramp - Depressed Existing Curb				
Code Ref:	CBC 1127B.5.1 and ADA/ABA 402.2

As Built Meas:	1	Quantity:	EACH	
Description:	No compliant curb cut at corner (intersection)			
As Built Desc:	7.7% running slope at depressed area			
Solution:	Demolish existing and construct curb cut			
Bar. Severity:	1 Necessary	Cost Estimate:	\$2,500.00	Status:
Implementation Priority:	2	Facility Function:		
Implementation Phase:		Implementation Date:		
Official Responsible:

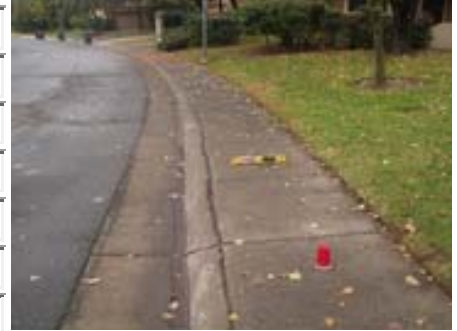
Field Date:	12/3/2010	Report Date:	12/3/2010	Barrier #:	3197
Location:	Crosswoods Cir - East				
X Coordinate:	-121.30199				
Y Coordinate:	38.6835				
Barrier Area:	Sidewalks				
Barrier Type:	Cross Slope - Existing (5.0% or more)				
Code Ref:	CBC 1133B.7.1.3 and ADA/ABA 403.3

As Built Meas:	132	Quantity:	LF		
Description:	Cross slope exceeds 2.0% (5.0% or more)				
As Built Desc:	6.9% cross slope				
Solution:	Demolish existing and construct new route				
Bar. Severity:	1 Necessary	Cost Estimate:	\$16,500.00	Status:	
Implementation Priority:	2	Facility Function:			
Implementation Phase:		Implementation Date:			
Official Responsible:

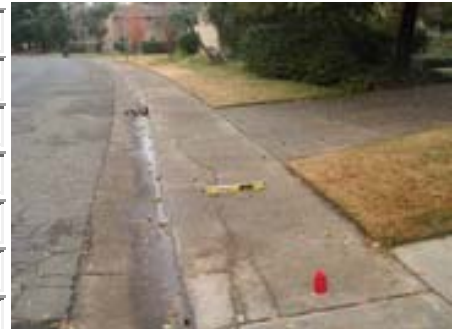
Field Date:	12/3/2010	Report Date:	12/3/2010	Barrier #:	3198
Location:	Crosswoods Cir - East				
X Coordinate:	-121.30264				
Y Coordinate:	38.68401				
Barrier Area:	Sidewalks				
Barrier Type:	Cross Slope - Existing (5.0% or more)				
Code Ref:	CBC 1133B.7.1.3 and ADA/ABA 403.3

As Built Meas:	156	Quantity:	LF		
Description:	Cross slope exceeds 2.0% (5.0% or more)				
As Built Desc:	5.8% cross slope				
Solution:	Demolish existing and construct new route				
Bar. Severity:	1 Necessary	Cost Estimate:	\$19,500.00	Status:	
Implementation Priority:	2	Facility Function:			
Implementation Phase:		Implementation Date:			
Official Responsible:

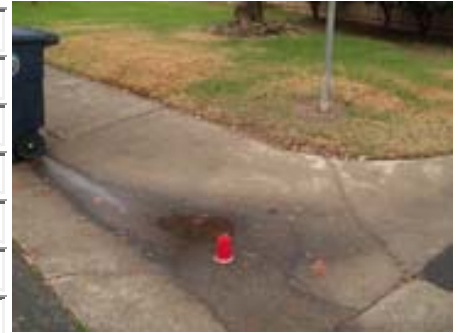
Field Date:	12/3/2010	Report Date:	12/3/2010	Barrier #:	3199
Location:	Crosswoods Cir and Amado Ct - Corner A				
X Coordinate:	-121.30328				
Y Coordinate:	38.6842				
Barrier Area:	Curb Ramps				
Barrier Type:	No Curb Ramp				
Code Ref:	CBC 1127B.5.1 and ADA/ABA 402.2

As Built Meas:	1	Quantity:	EACH	
Description:	No curb cut at corner (intersection)			
As Built Desc:	No curb ramp at corner			
Solution:	Demolish existing and construct curb cut			
Bar. Severity:	1 Necessary	Cost Estimate:	\$2,500.00	Status:
Implementation Priority:	2	Facility Function:		
Implementation Phase:		Implementation Date:		
Official Responsible:

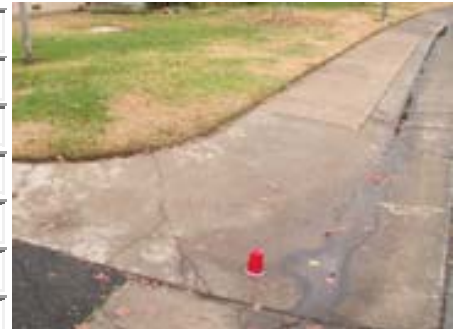
Field Date:	12/3/2010	Report Date:	12/3/2010	Barrier #:	3200
Location:	Crosswoods Cir and Amado Ct - Corner B				
X Coordinate:	-121.30316				
Y Coordinate:	38.68417				
Barrier Area:	Curb Ramps				
Barrier Type:	No Curb Ramp				
Code Ref:	CBC 1127B.5.1 and ADA/ABA 402.2

As Built Meas:	1	Quantity:	EACH	
Description:	No curb cut at corner (intersection)			
As Built Desc:	No curb ramp at corner			
Solution:	Demolish existing and construct curb cut			
Bar. Severity:	1 Necessary	Cost Estimate:	\$2,500.00	Status:
Implementation Priority:	2	Facility Function:		
Implementation Phase:		Implementation Date:		
Official Responsible:

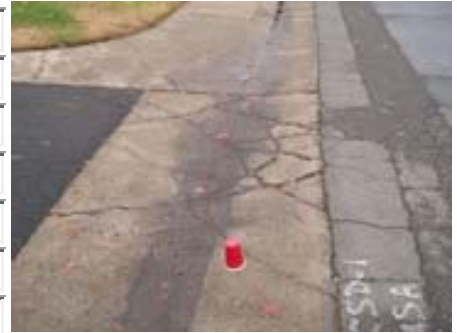
Field Date:	12/3/2010	Report Date:	12/3/2010	Barrier #:	3201
Location:	Crosswoods Cir - East				
X Coordinate:	-121.30319				
Y Coordinate:	38.68417				
Barrier Area:	Sidewalks				
Barrier Type:	Surface Condition - Damaged				
Code Ref:	CBC 1133B.7.1 and ADA/ABA 302.1

As Built Meas:	10	Quantity:	LF	
Description:	Surface is not firm and stable (cracked, broken or loose soil, etc.)			
As Built Desc:	Cracked concrete			
Solution:	Repair surface to make firm and stable			
Bar. Severity:	1 Necessary	Cost Estimate:	\$1,250.00	Status:
Implementation Priority:	2	Facility Function:		
Implementation Phase:		Implementation Date:		
Official Responsible:

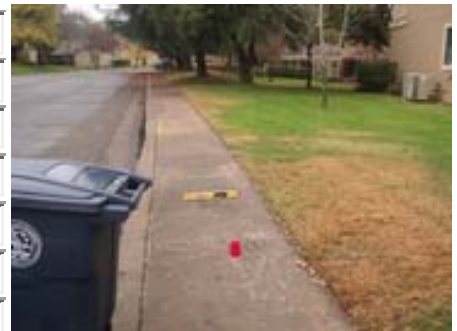
Field Date:	12/3/2010	Report Date:	12/3/2010	Barrier #:	3202
Location:	Crosswoods Cir - East				
X Coordinate:	-121.30332				
Y Coordinate:	38.68419				
Barrier Area:	Sidewalks				
Barrier Type:	Cross Slope - Existing (4.1% to 4.9%)				
Code Ref:	CBC 1133B.7.1.3 and ADA/ABA 403.3

As Built Meas:	426	Quantity:	LF	
Description:	Cross slope exceeds 2.0% (4.1% to 4.9%)			
As Built Desc:	4.6% cross slope			
Solution:	Demolish existing and construct new route			
Bar. Severity:	2 Recommended	Cost Estimate:	\$53,250.00	Status:
Implementation Priority:	2	Facility Function:		
Implementation Phase:		Implementation Date:		
Official Responsible:

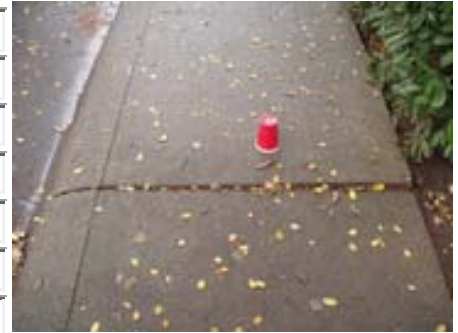
Barrier Type: Abrupt Change in Level - > 1/2"

Code Ref: CBC 1133B.7.1 and ADA/ABA 303.3

As Built Meas: 4 Quantity: LF

Description: Change in level greater than 1/2"

Solution: Grind or repair sidewalk to remove trip hazard

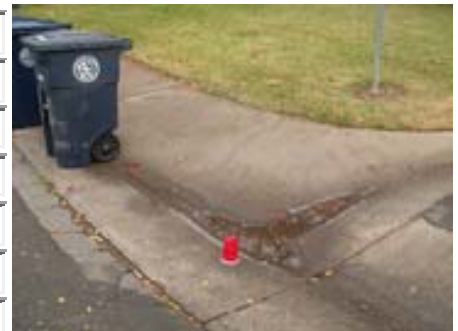
Barrier Type: No Curb Ramp

Code Ref: CBC 1127B.5.1 and ADA/ABA 402.2

As Built Meas: 1 Quantity: EACH

Description: No curb cut at corner (intersection)

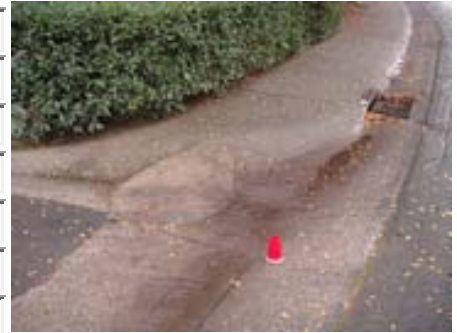
Field Date:	12/3/2010	Report Date:	12/3/2010	Barrier #:	3205
Location:	Crosswoods Cir and San Angelo Ct - Corner C				
X Coordinate:	-121.30464				
Y Coordinate:	38.68493				
Barrier Area:	Curb Ramps				
Barrier Type:	No Curb Ramp				
Code Ref:	CBC 1127B.5.1 and ADA/ABA 402.2

As Built Meas:	1	Quantity:	EACH	
Description:	No curb cut at corner (intersection)			
As Built Desc:	No curb ramp at corner			
Solution:	Demolish existing and construct curb cut			
Bar. Severity:	1 Necessary	Cost Estimate:	\$2,500.00	Status:
Implementation Priority:	2	Facility Function:		
Implementation Phase:		Implementation Date:		
Official Responsible:

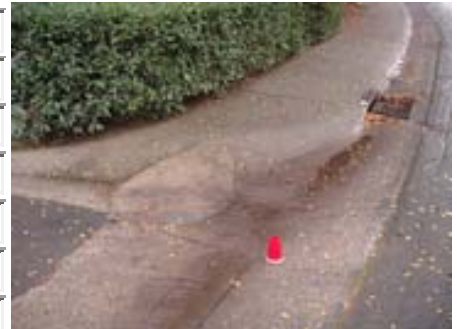
Field Date:	12/3/2010	Report Date:	12/3/2010	Barrier #:	3206
Location:	Crosswoods Cir - East				
X Coordinate:	-121.30451				
Y Coordinate:	38.68586				
Barrier Area:	Sidewalks				
Barrier Type:	Cross Slope - Existing (5.0% or more)				
Code Ref:	CBC 1133B.7.1.3 and ADA/ABA 403.3

As Built Meas:	293	Quantity:	LF	
Description:	Cross slope exceeds 2.0% (5.0% or more)			
As Built Desc:	6.0% cross slope			
Solution:	Demolish existing and construct new route			
Bar. Severity:	1 Necessary	Cost Estimate:	\$36,625.00	Status:
Implementation Priority:	2	Facility Function:		
Implementation Phase:		Implementation Date:		
Official Responsible:

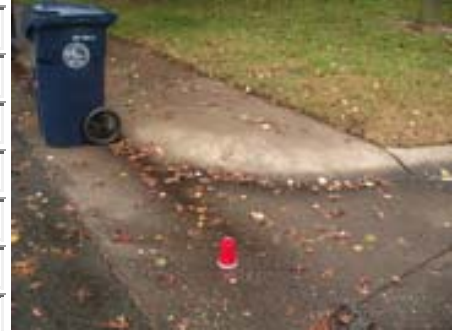
Field Date:	12/3/2010	Report Date:	12/3/2010	Barrier #:	3207
Location:	Crosswoods Cir and Monticello Ct - Corner B				
X Coordinate:	-121.30451				
Y Coordinate:	38.68592				
Barrier Area:	Curb Ramps				
Barrier Type:	No Curb Ramp				
Code Ref:	CBC 1127B.5.1 and ADA/ABA 402.2

As Built Meas:	1	Quantity:	EACH	
Description:	No curb cut at corner (intersection)			
As Built Desc:	No curb ramp at corner			
Solution:	Demolish existing and construct curb cut			
Bar. Severity:	1 Necessary	Cost Estimate:	\$2,500.00	Status:
Implementation Priority:	2	Facility Function:		
Implementation Phase:		Implementation Date:		
Official Responsible:

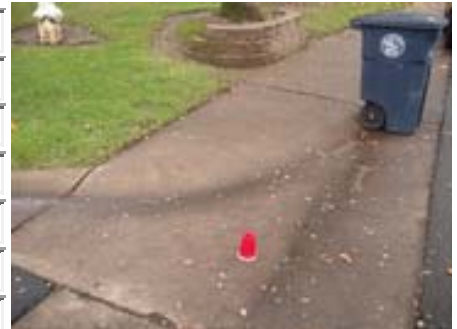
Field Date:	12/3/2010	Report Date:	12/3/2010	Barrier #:	3208
Location:	Crosswoods Cir and Monticello Ct - Corner C				
X Coordinate:	-121.30451				
Y Coordinate:	38.68586				
Barrier Area:	Curb Ramps				
Barrier Type:	No Curb Ramp				
Code Ref:	CBC 1127B.5.1 and ADA/ABA 402.2

As Built Meas:	1	Quantity:	EACH	
Description:	No curb cut at corner (intersection)			
As Built Desc:	No curb ramp at corner			
Solution:	Demolish existing and construct curb cut			
Bar. Severity:	1 Necessary	Cost Estimate:	\$2,500.00	Status:
Implementation Priority:	2	Facility Function:		
Implementation Phase:		Implementation Date:		
Official Responsible:

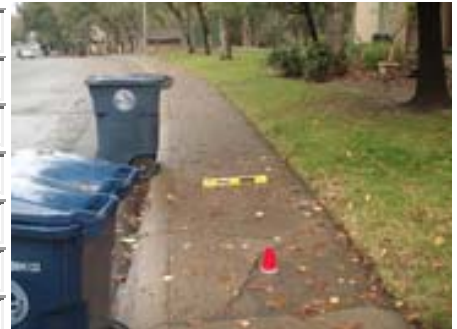
Barrier Type: Cross Slope - Existing (4.1% to 4.9%)

Code Ref: CBC 1133B.7.1.3 and ADA/ABA 403.3

As Built Meas: 364 Quantity: LF

Description: Cross slope exceeds 2.0% (4.1% to 4.9%)

Bar. Severity: 2 Recommended Cost Estimate: \$45,500.00 Status:

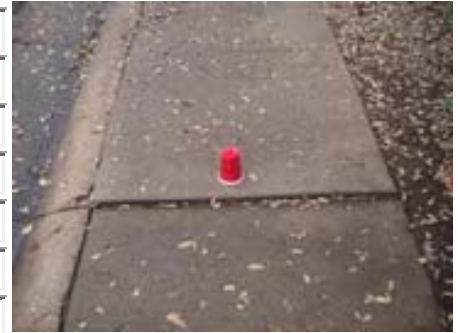
Field Date:	12/3/2010	Report Date:	12/3/2010	Barrier #:	3210B
Location:	Crosswoods Cir - East				
X Coordinate:	-121.30485				
Y Coordinate:	38.68646				
Barrier Area:	Sidewalks				
Barrier Type:	Abrupt Change in Level - > 1/2"				
Code Ref:	CBC 1133B.7.1 and ADA/ABA 303.3

As Built Meas:	4	Quantity:	LF
Description:	Change in level greater than 1/2"		
As Built Desc:	1" lip in sidewalk surface		
Solution:	Grind or repair sidewalk to remove trip hazard		
Bar. Severity:	1 Necessary	Cost Estimate:	\$1,000.00
Implementation Priority:	2	Facility Function:	
Implementation Phase:		Implementation Date:	
Official Responsible:

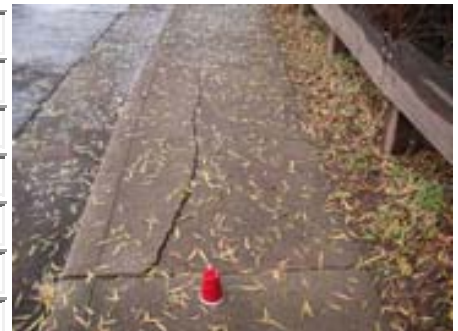
Field Date:	12/3/2010	Report Date:	12/3/2010	Barrier #:	3211
Location:	Crosswoods Cir - East				
X Coordinate:	-121.30549				
Y Coordinate:	38.68757				
Barrier Area:	Sidewalks				
Barrier Type:	Surface Condition - Damaged				
Code Ref:	CBC 1133B.7.1 and ADA/ABA 302.1

As Built Meas:	20	Quantity:	LF
Description:	Surface is not firm and stable (cracked, broken or loose soil, etc.)		
As Built Desc:	Cracked concrete		
Solution:	Repair surface to make firm and stable		
Bar. Severity:	1 Necessary	Cost Estimate:	\$2,500.00
Implementation Priority:	2	Facility Function:	
Implementation Phase:		Implementation Date:	
Official Responsible:

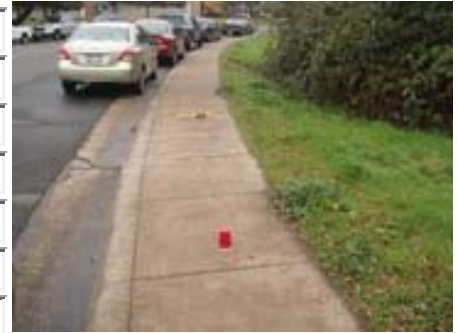
Field Date:	12/3/2010	Report Date:	12/3/2010	Barrier #:	3212
Location:	Crosswoods Cir - East				
X Coordinate:	-121.30538				
Y Coordinate:	38.68787				
Barrier Area:	Sidewalks				
Barrier Type:	Cross Slope - Existing (3.1% to 4.0%)				
Code Ref:	CBC 1133B.7.1.3 and ADA/ABA 403.3

As Built Meas:	115	Quantity:	LF	
Description:	Cross slope exceeds 2.0% (3.1% to 4.0%)			
As Built Desc:	3.6% cross slope			
Solution:	Demolish existing and construct new route			
Bar. Severity:	3 Hinderance	Cost Estimate:	\$14,375.00	Status:
Implementation Priority:	2	Facility Function:		
Implementation Phase:		Implementation Date:		
Official Responsible:

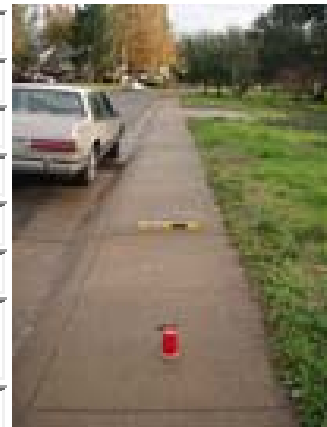
Field Date:	12/6/2010	Report Date:	12/6/2010	Barrier #:	3213A
Location:	Crosswoods Cir - South				
X Coordinate:	-121.30506				
Y Coordinate:	38.68817				
Barrier Area:	Sidewalks				
Barrier Type:	Cross Slope - Existing (4.1% to 4.9%)				
Code Ref:	CBC 1133B.7.1.3 and ADA/ABA 403.3

As Built Meas:	152	Quantity:	LF	
Description:	Cross slope exceeds 2.0% (4.1% to 4.9%)			
As Built Desc:	4.4% cross slope			
Solution:	Demolish existing and construct new route			
Bar. Severity:	2 Recommended	Cost Estimate:	\$19,000.00	Status:
Implementation Priority:	2	Facility Function:		
Implementation Phase:		Implementation Date:		
Official Responsible:

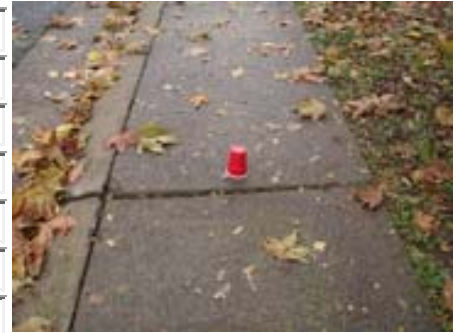
Field Date:	12/6/2010	Report Date:	12/6/2010	Barrier #:	3213B
Location:	Crosswoods Cir - South				
X Coordinate:	-121.3046				
Y Coordinate:	38.68846				
Barrier Area:	Sidewalks				
Barrier Type:	Abrupt Change in Level - > 1/2"				
Code Ref:	CBC 1133B.7.1 and ADA/ABA 303.3

As Built Meas:	4	Quantity:	LF
Description:	Change in level greater than 1/2"		
As Built Desc:	1/2" lip in sidewalk surface		
Solution:	Grind or repair sidewalk to remove trip hazard		
Bar. Severity:	1 Necessary	Cost Estimate:	\$1,000.00
Implementation Priority:	2	Facility Function:	
Implementation Phase:		Implementation Date:	
Official Responsible:

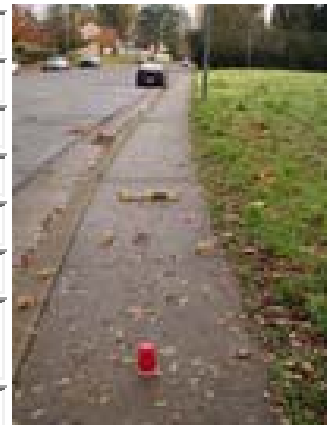
Field Date:	12/6/2010	Report Date:	12/6/2010	Barrier #:	3214
Location:	Crosswoods Cir - South				
X Coordinate:	-121.30414				
Y Coordinate:	38.68858				
Barrier Area:	Sidewalks				
Barrier Type:	Cross Slope - Existing (5.0% or more)				
Code Ref:	CBC 1133B.7.1.3 and ADA/ABA 403.3

As Built Meas:	486	Quantity:	LF
Description:	Cross slope exceeds 2.0% (5.0% or more)		
As Built Desc:	5.3% cross slope		
Solution:	Demolish existing and construct new route		
Bar. Severity:	1 Necessary	Cost Estimate:	\$60,750.00
Implementation Priority:	2	Facility Function:	
Implementation Phase:		Implementation Date:	
Official Responsible:

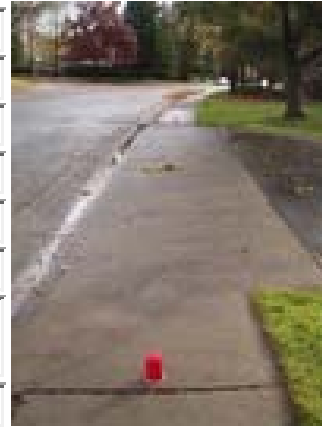
Field Date: 12/6/2010 Report Date: 12/6/2010 Barrier #: 3215  
Location: Crosswoods Cir - South  
X Coordinate: -121.30275  
Y Coordinate: 38.6886  
Barrier Area: Sidewalks  
Barrier Type: Driveway - Existing (5.0% or more)  
Code Ref: CBC 1133B.7.1.3 and ADA/ABA 403.3

As Built Meas: 31 Quantity: LF  
Description: Driveway cross slope exceeds 2.0% (5.0% or more)  
As Built Desc: 8.2% cross slope  
Solution: Provide min. 48" wide level walkway through driveway  
Bar. Severity: 4 Low Severity Cost Estimate: \$3,875.00 Status:  
Implementation Priority: 2 Facility Function:  
Implementation Phase: Implementation Date:  
Official Responsible:

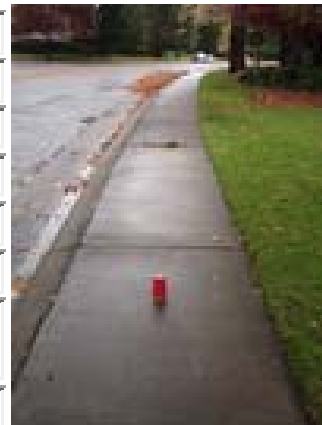
Field Date: 12/6/2010 Report Date: 12/6/2010 Barrier #: 3216  
Location: Crosswoods Cir - South  
X Coordinate: -121.30268  
Y Coordinate: 38.68855  
Barrier Area: Sidewalks  
Barrier Type: Cross Slope - Existing (4.1% to 4.9%)  
Code Ref: CBC 1133B.7.1.3 and ADA/ABA 403.3

As Built Meas: 440 Quantity: LF  
Description: Cross slope exceeds 2.0% (4.1% to 4.9%)  
As Built Desc: 4.1% cross slope  
Solution: Demolish existing and construct new route  
Bar. Severity: 2 Recommended Cost Estimate: \$55,000.00 Status:  
Implementation Priority: 2 Facility Function:  
Implementation Phase: Implementation Date:  
Official Responsible:

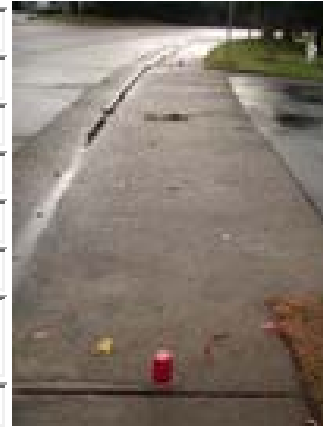
Field Date:	12/6/2010	Report Date:	12/6/2010	Barrier #:	3217
Location:	Crosswoods Cir - West				
X Coordinate:	-121.30131				
Y Coordinate:	38.68797				
Barrier Area:	Sidewalks				
Barrier Type:	Driveway - Existing (5.0% or more)				
Code Ref:	CBC 1133B.7.1.3 and ADA/ABA 403.3

As Built Meas:	38	Quantity:	LF		
Description:	Driveway cross slope exceeds 2.0% (5.0% or more)				
As Built Desc:	8.1% cross slope				
Solution:	Provide min. 48" wide level walkway through driveway				
Bar. Severity:	4 Low Severity	Cost Estimate:	\$4,750.00	Status:	
Implementation Priority:	2	Facility Function:			
Implementation Phase:		Implementation Date:			
Official Responsible:

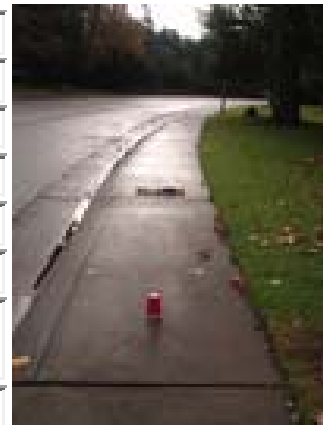
Field Date:	12/6/2010	Report Date:	12/6/2010	Barrier #:	3218
Location:	Crosswoods Cir - West				
X Coordinate:	-121.30126				
Y Coordinate:	38.68787				
Barrier Area:	Sidewalks				
Barrier Type:	Cross Slope - Existing (5.0% or more)				
Code Ref:	CBC 1133B.7.1.3 and ADA/ABA 403.3

As Built Meas:	178	Quantity:	LF		
Description:	Cross slope exceeds 2.0% (5.0% or more)				
As Built Desc:	5.1% cross slope				
Solution:	Demolish existing and construct new route				
Bar. Severity:	1 Necessary	Cost Estimate:	\$22,250.00	Status:	
Implementation Priority:	2	Facility Function:			
Implementation Phase:		Implementation Date:			
Official Responsible:

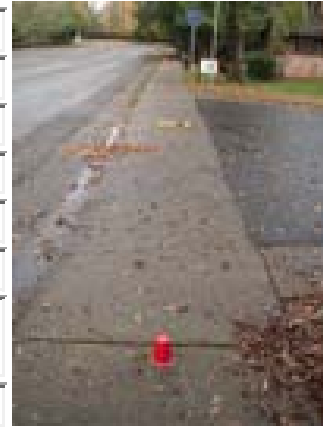
Field Date:	12/6/2010	Report Date:	12/6/2010	Barrier #:	3219
Location:	Crosswoods Cir - East				
X Coordinate:	-121.30086				
Y Coordinate:	38.68676				
Barrier Area:	Sidewalks				
Barrier Type:	Driveway - Existing (5.0% or more)				
Code Ref:	CBC 1133B.7.1.3 and ADA/ABA 403.3

As Built Meas:	35	Quantity:	LF		
Description:	Driveway cross slope exceeds 2.0% (5.0% or more)				
As Built Desc:	5.3% cross slope				
Solution:	Provide min. 48" wide level walkway through driveway				
Bar. Severity:	4 Low Severity	Cost Estimate:	\$4,375.00	Status:	
Implementation Priority:	2	Facility Function:			
Implementation Phase:		Implementation Date:			
Official Responsible:

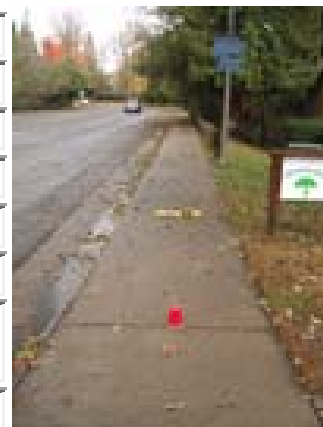
Field Date:	12/6/2010	Report Date:	12/6/2010	Barrier #:	3220
Location:	Crosswoods Cir - East				
X Coordinate:	-121.30088				
Y Coordinate:	38.68734				
Barrier Area:	Sidewalks				
Barrier Type:	Cross Slope - Existing (4.1% to 4.9%)				
Code Ref:	CBC 1133B.7.1.3 and ADA/ABA 403.3

As Built Meas:	38	Quantity:	LF		
Description:	Cross slope exceeds 2.0% (4.1% to 4.9%)				
As Built Desc:	4.7% cross slope				
Solution:	Demolish existing and construct new route				
Bar. Severity:	2 Recommended	Cost Estimate:	\$4,750.00	Status:	
Implementation Priority:	2	Facility Function:			
Implementation Phase:		Implementation Date:			
Official Responsible:

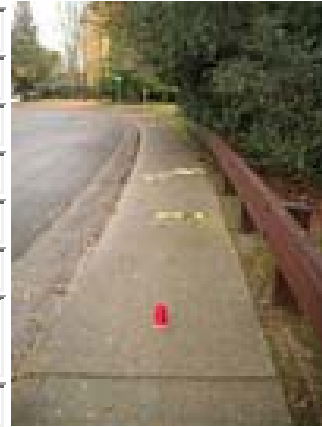
Field Date:	12/6/2010	Report Date:	12/6/2010	Barrier #:	3221
Location:	Crosswoods Cir - East				
X Coordinate:	-121.30095				
Y Coordinate:	38.68771				
Barrier Area:	Sidewalks				
Barrier Type:	Cross Slope - Existing (4.1% to 4.9%)				
Code Ref:	CBC 1133B.7.1.3 and ADA/ABA 403.3

As Built Meas:	114	Quantity:	LF		
Description:	Cross slope exceeds 2.0% (4.1% to 4.9%)				
As Built Desc:	4.1% cross slope				
Solution:	Demolish existing and construct new route				
Bar. Severity:	2 Recommended	Cost Estimate:	\$14,250.00	Status:	
Implementation Priority:	2	Facility Function:			
Implementation Phase:		Implementation Date:			
Official Responsible:

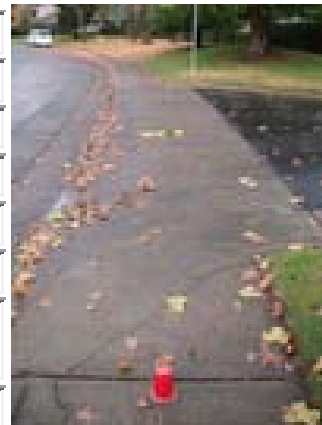
Field Date:	12/6/2010	Report Date:	12/6/2010	Barrier #:	3222
Location:	Crosswoods Cir - East				
X Coordinate:	-121.30101				
Y Coordinate:	38.68781				
Barrier Area:	Sidewalks				
Barrier Type:	Driveway - Existing (5.0% or more)				
Code Ref:	CBC 1133B.7.1.3 and ADA/ABA 403.3

As Built Meas:	39	Quantity:	LF		
Description:	Driveway cross slope exceeds 2.0% (5.0% or more)				
As Built Desc:	7.0% cross slope				
Solution:	Provide min. 48" wide level walkway through driveway				
Bar. Severity:	4 Low Severity	Cost Estimate:	\$4,875.00	Status:	
Implementation Priority:	2	Facility Function:			
Implementation Phase:		Implementation Date:			
Official Responsible:

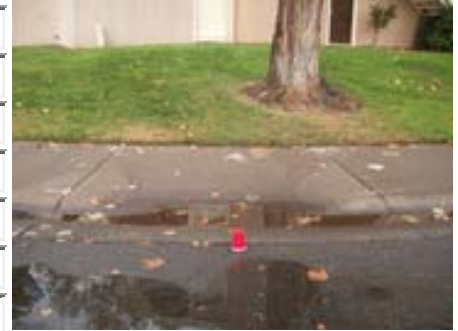
Field Date:	12/6/2010	Report Date:	12/6/2010	Barrier #:	3223
Location:	Crosswoods Cir and San Tomas Dr - Corner A				
X Coordinate:	-121.30208				
Y Coordinate:	38.68864				
Barrier Area:	Curb Ramps				
Barrier Type:	No Curb Ramp - Depressed Existing Curb				
Code Ref:	CBC 1127B.5.1 and ADA/ABA 402.2

As Built Meas:	1	Quantity:	EACH
Description:	No compliant curb cut at corner (intersection)		
As Built Desc:	8.6% running slope at depressed area		
Solution:	Demolish existing and construct curb cut		
Bar. Severity:	1 Necessary	Cost Estimate:	\$2,500.00
Implementation Priority:	2	Facility Function:	
Implementation Phase:		Implementation Date:	
Official Responsible:

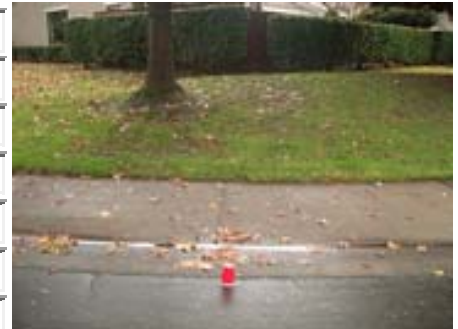
Field Date:	12/6/2010	Report Date:	12/6/2010	Barrier #:	3224
Location:	Crosswoods Cir and San Tomas Dr - Corner B				
X Coordinate:	-121.30199				
Y Coordinate:	38.68858				
Barrier Area:	Curb Ramps				
Barrier Type:	No Curb Ramp - Depressed Existing Curb				
Code Ref:	CBC 1127B.5.1 and ADA/ABA 402.2

As Built Meas:	1	Quantity:	EACH
Description:	No compliant curb cut at corner (intersection)		
As Built Desc:	10.2% running slope at depressed area		
Solution:	Demolish existing and construct curb cut		
Bar. Severity:	1 Necessary	Cost Estimate:	\$2,500.00
Implementation Priority:	2	Facility Function:	
Implementation Phase:		Implementation Date:	
Official Responsible:

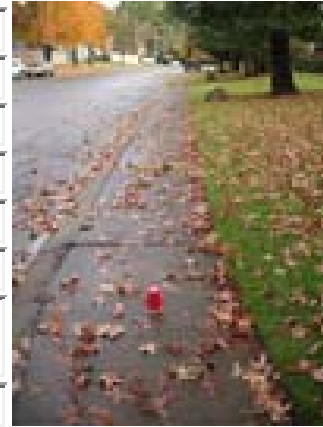
Field Date:	12/6/2010	Report Date:	12/6/2010	Barrier #:	3225
Location:	San Tomas Dr - East				
X Coordinate:	-121.30199				
Y Coordinate:	38.68866				
Barrier Area:	Sidewalks				
Barrier Type:	Cross Slope - Existing (3.1% to 4.0%)				
Code Ref:	CBC 1133B.7.1.3 and ADA/ABA 403.3

As Built Meas:	264	Quantity:	LF	
Description:	Cross slope exceeds 2.0% (3.1% to 4.0%)			
As Built Desc:	4.0% cross slope			
Solution:	Demolish existing and construct new route			
Bar. Severity:	3 Hinderance	Cost Estimate:	\$33,000.00	Status:
Implementation Priority:	4	Facility Function:		
Implementation Phase:		Implementation Date:		
Official Responsible:

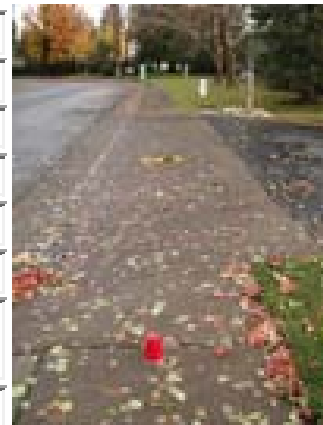
Field Date:	12/6/2010	Report Date:	12/6/2010	Barrier #:	3226
Location:	San Tomas Dr - East				
X Coordinate:	-121.30149				
Y Coordinate:	38.68928				
Barrier Area:	Sidewalks				
Barrier Type:	Driveway - Existing (5.0% or more)				
Code Ref:	CBC 1133B.7.1.3 and ADA/ABA 403.3

As Built Meas:	38	Quantity:	LF	
Description:	Driveway cross slope exceeds 2.0% (5.0% or more)			
As Built Desc:	5.1% cross slope			
Solution:	Provide min. 48" wide level walkway through driveway			
Bar. Severity:	4 Low Severity	Cost Estimate:	\$4,750.00	Status:
Implementation Priority:	4	Facility Function:		
Implementation Phase:		Implementation Date:		
Official Responsible:

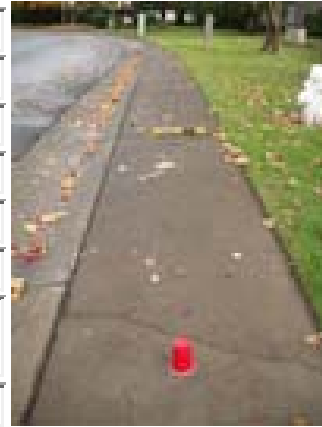
Field Date:	12/6/2010	Report Date:	12/6/2010	Barrier #:	3227
Location:	San Tomas Dr - East				
X Coordinate:	-121.3014				
Y Coordinate:	38.68937				
Barrier Area:	Sidewalks				
Barrier Type:	Cross Slope - Existing (4.1% to 4.9%)				
Code Ref:	CBC 1133B.7.1.3 and ADA/ABA 403.3

As Built Meas:	172	Quantity:	LF	
Description:	Cross slope exceeds 2.0% (4.1% to 4.9%)			
As Built Desc:	4.9% cross slope			
Solution:	Demolish existing and construct new route			
Bar. Severity:	2 Recommended	Cost Estimate:	\$21,500.00	Status:
Implementation Priority:	4	Facility Function:		
Implementation Phase:		Implementation Date:		
Official Responsible:

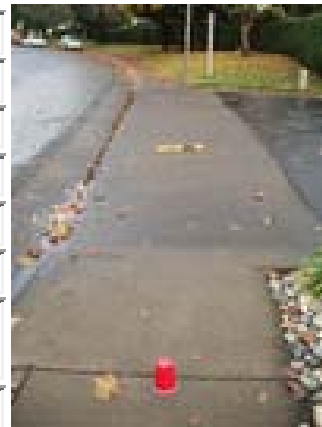
Field Date:	12/6/2010	Report Date:	12/6/2010	Barrier #:	3228
Location:	San Tomas Dr - East				
X Coordinate:	-121.30112				
Y Coordinate:	38.68979				
Barrier Area:	Sidewalks				
Barrier Type:	Driveway - Existing (5.0% or more)				
Code Ref:	CBC 1133B.7.1.3 and ADA/ABA 403.3

As Built Meas:	39	Quantity:	LF	
Description:	Driveway cross slope exceeds 2.0% (5.0% or more)			
As Built Desc:	7.1% cross slope			
Solution:	Provide min. 48" wide level walkway through driveway			
Bar. Severity:	4 Low Severity	Cost Estimate:	\$4,875.00	Status:
Implementation Priority:	4	Facility Function:		
Implementation Phase:		Implementation Date:		
Official Responsible:

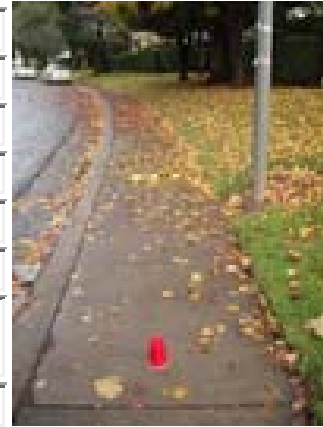
Field Date:	12/6/2010	Report Date:	12/6/2010	Barrier #:	3229
Location:	San Tomas Dr - East				
X Coordinate:	-121.30114				
Y Coordinate:	38.68985				
Barrier Area:	Sidewalks				
Barrier Type:	Cross Slope - Existing (4.1% to 4.9%)				
Code Ref:	CBC 1133B.7.1.3 and ADA/ABA 403.3

As Built Meas:	338	Quantity:	LF	
Description:	Cross slope exceeds 2.0% (4.1% to 4.9%)			
As Built Desc:	4.7% cross slope			
Solution:	Demolish existing and construct new route			
Bar. Severity:	2 Recommended	Cost Estimate:	\$42,250.00	Status:
Implementation Priority:	4	Facility Function:		
Implementation Phase:		Implementation Date:		
Official Responsible:

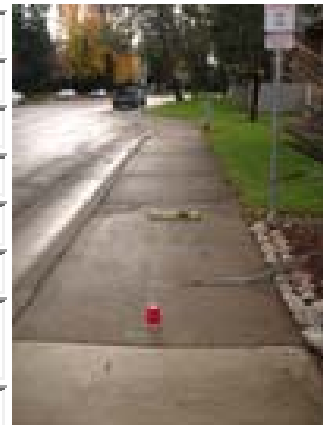
Field Date:	12/6/2010	Report Date:	12/6/2010	Barrier #:	3230
Location:	San Tomas Dr - West				
X Coordinate:	-121.30145				
Y Coordinate:	38.69037				
Barrier Area:	Sidewalks				
Barrier Type:	Cross Slope - Existing (5.0% or more)				
Code Ref:	CBC 1133B.7.1.3 and ADA/ABA 403.3

As Built Meas:	201	Quantity:	LF	
Description:	Cross slope exceeds 2.0% (5.0% or more)			
As Built Desc:	5.1% cross slope			
Solution:	Demolish existing and construct new route			
Bar. Severity:	1 Necessary	Cost Estimate:	\$25,125.00	Status:
Implementation Priority:	4	Facility Function:		
Implementation Phase:		Implementation Date:		
Official Responsible:

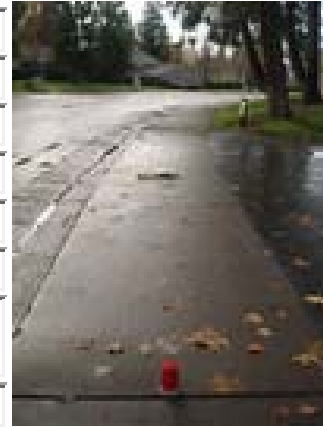
Field Date:	12/6/2010	Report Date:	12/6/2010	Barrier #:	3231
Location:	San Tomas Dr - West				
X Coordinate:	-121.3013				
Y Coordinate:	38.69007				
Barrier Area:	Sidewalks				
Barrier Type:	Driveway - Existing (5.0% or more)				
Code Ref:	CBC 1133B.7.1.3 and ADA/ABA 403.3

As Built Meas:	40	Quantity:	LF	
Description:	Driveway cross slope exceeds 2.0% (5.0% or more)			
As Built Desc:	6.7% cross slope			
Solution:	Provide min. 48" wide level walkway through driveway			
Bar. Severity:	4 Low Severity	Cost Estimate:	\$5,000.00	Status:
Implementation Priority:	4	Facility Function:		
Implementation Phase:		Implementation Date:		
Official Responsible:

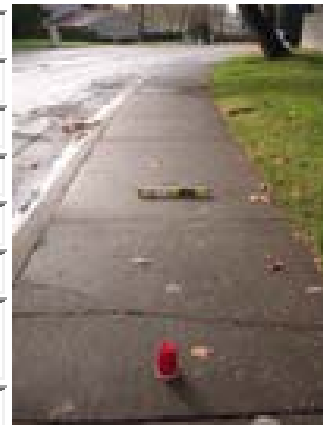
Field Date:	12/6/2010	Report Date:	12/6/2010	Barrier #:	3232A
Location:	San Tomas Dr - West				
X Coordinate:	-121.30198				
Y Coordinate:	38.6889				
Barrier Area:	Sidewalks				
Barrier Type:	Cross Slope - Existing (5.0% or more)				
Code Ref:	CBC 1133B.7.1.3 and ADA/ABA 403.3

As Built Meas:	457	Quantity:	LF	
Description:	Cross slope exceeds 2.0% (5.0% or more)			
As Built Desc:	5.2% cross slope			
Solution:	Demolish existing and construct new route			
Bar. Severity:	1 Necessary	Cost Estimate:	\$57,125.00	Status:
Implementation Priority:	4	Facility Function:		
Implementation Phase:		Implementation Date:		
Official Responsible:

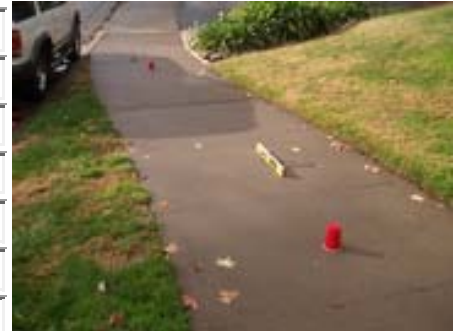
Field Date:	12/6/2010	Report Date:	12/6/2010	Barrier #:	3232B
Location:	San Tomas Dr - West				
X Coordinate:	-121.302				
Y Coordinate:	38.68888				
Barrier Area:	Sidewalks				
Barrier Type:	Running Slope (Existing)				
Code Ref:	CBC 1133B.7.3 and ADA/ABA 403.3

As Built Meas:	20	Quantity:	LF	
Description:	Running slope exceeds 5.0%			
As Built Desc:	7.6% running slope			
Solution:	No remediation where sidewalk sloped as roadway			
Bar. Severity:	5 Technically Infeasible	Cost Estimate:	\$0.00	Status:
Implementation Priority:	4	Facility Function:		
Implementation Phase:		Implementation Date:		
Official Responsible:

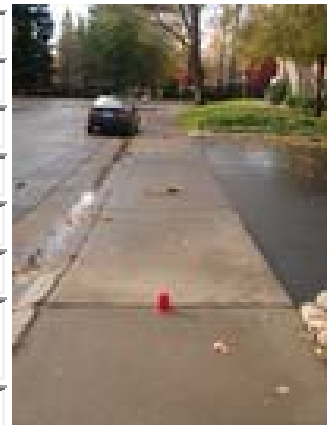
Field Date:	12/6/2010	Report Date:	12/6/2010	Barrier #:	3233
Location:	San Tomas Dr - West				
X Coordinate:	-121.30209				
Y Coordinate:	38.68882				
Barrier Area:	Sidewalks				
Barrier Type:	Driveway - Existing (5.0% or more)				
Code Ref:	CBC 1133B.7.1.3 and ADA/ABA 403.3

As Built Meas:	42	Quantity:	LF	
Description:	Driveway cross slope exceeds 2.0% (5.0% or more)			
As Built Desc:	7.0% cross slope			
Solution:	Provide min. 48" wide level walkway through driveway			
Bar. Severity:	4 Low Severity	Cost Estimate:	\$5,250.00	Status:
Implementation Priority:	4	Facility Function:		
Implementation Phase:		Implementation Date:		
Official Responsible:

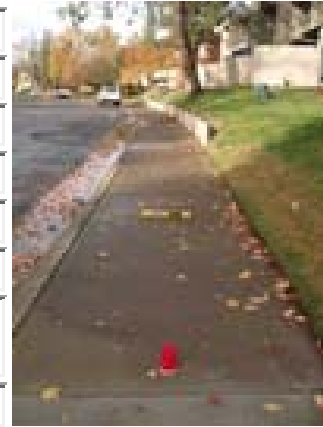
Field Date:	12/6/2010	Report Date:	12/6/2010	Barrier #:	3234
Location:	Crosswoods Cir - North				
X Coordinate:	-121.30238				
Y Coordinate:	38.68862				
Barrier Area:	Sidewalks				
Barrier Type:	Cross Slope - Existing (3.1% to 4.0%)				
Code Ref:	CBC 1133B.7.1.3 and ADA/ABA 403.3

As Built Meas:	463	Quantity:	LF	
Description:	Cross slope exceeds 2.0% (3.1% to 4.0%)			
As Built Desc:	3.8% cross slope			
Solution:	Demolish existing and construct new route			
Bar. Severity:	3 Hinderance	Cost Estimate:	\$57,875.00	Status:
Implementation Priority:	2	Facility Function:		
Implementation Phase:		Implementation Date:		
Official Responsible:

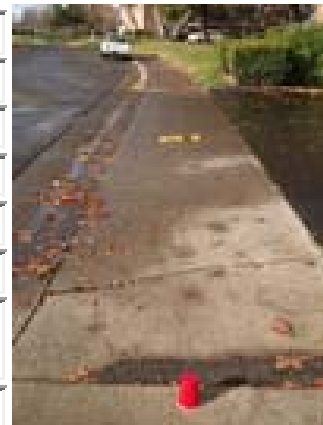
Field Date:	12/6/2010	Report Date:	12/6/2010	Barrier #:	3235
Location:	Crosswoods Cir - North				
X Coordinate:	-121.30403				
Y Coordinate:	38.68877				
Barrier Area:	Sidewalks				
Barrier Type:	Driveway - Existing (5.0% or more)				
Code Ref:	CBC 1133B.7.1.3 and ADA/ABA 403.3

As Built Meas:	40	Quantity:	LF	
Description:	Driveway cross slope exceeds 2.0% (5.0% or more)			
As Built Desc:	8.2% cross slope			
Solution:	Provide min. 48" wide level walkway through driveway			
Bar. Severity:	4 Low Severity	Cost Estimate:	\$5,000.00	Status:
Implementation Priority:	2	Facility Function:		
Implementation Phase:		Implementation Date:		
Official Responsible:

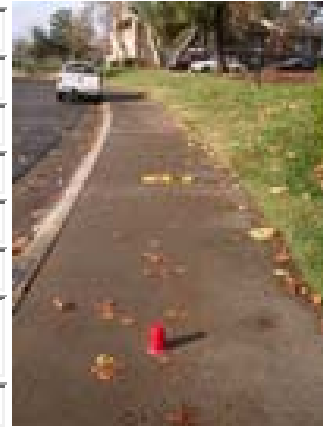
Field Date:	12/6/2010	Report Date:	12/6/2010	Barrier #:	3236
Location:	Crosswoods Cir - North				
X Coordinate:	-121.30415				
Y Coordinate:	38.68873				
Barrier Area:	Sidewalks				
Barrier Type:	Cross Slope - Existing (3.1% to 4.0%)				
Code Ref:	CBC 1133B.7.1.3 and ADA/ABA 403.3

As Built Meas:	203	Quantity:	LF	
Description:	Cross slope exceeds 2.0% (3.1% to 4.0%)			
As Built Desc:	3.9% cross slope			
Solution:	Demolish existing and construct new route			
Bar. Severity:	3 Hinderance	Cost Estimate:	\$25,375.00	Status:
Implementation Priority:	2	Facility Function:		
Implementation Phase:		Implementation Date:		
Official Responsible:

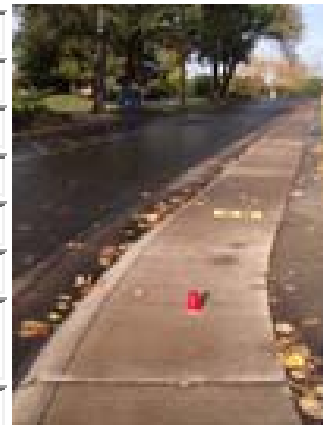
Field Date:	12/6/2010	Report Date:	12/6/2010	Barrier #:	3237
Location:	Crosswoods Pkwy - North				
X Coordinate:	-121.30493				
Y Coordinate:	38.68857				
Barrier Area:	Sidewalks				
Barrier Type:	Cross Slope - Existing (3.1% to 4.0%)				
Code Ref:	CBC 1133B.7.1.3 and ADA/ABA 403.3

As Built Meas:	227	Quantity:	LF	
Description:	Cross slope exceeds 2.0% (3.1% to 4.0%)			
As Built Desc:	3.6% cross slope			
Solution:	Demolish existing and construct new route			
Bar. Severity:	3 Hinderance	Cost Estimate:	\$28,375.00	Status:
Implementation Priority:	2	Facility Function:		
Implementation Phase:		Implementation Date:		
Official Responsible:

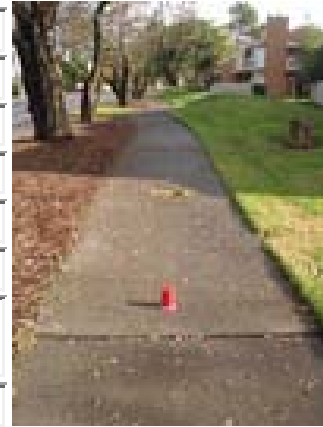
Field Date:	12/6/2010	Report Date:	12/6/2010	Barrier #:	3238
Location:	Auburn Blvd - East				
X Coordinate:	-121.3048				
Y Coordinate:	38.68951				
Barrier Area:	Sidewalks				
Barrier Type:	Cross Slope - Existing (5.0% or more)				
Code Ref:	CBC 1133B.7.1.3 and ADA/ABA 403.3

As Built Meas:	702	Quantity:	LF		
Description:	Cross slope exceeds 2.0% (5.0% or more)				
As Built Desc:	5.5% cross slope				
Solution:	Demolish existing and construct new route				
Bar. Severity:	1 Necessary	Cost Estimate:	\$87,750.00	Status:	
Implementation Priority:	1	Facility Function:			
Implementation Phase:		Implementation Date:			
Official Responsible:

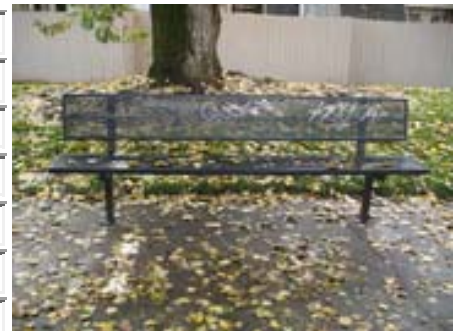
Field Date:	12/6/2010	Report Date:	12/6/2010	Barrier #:	3239A
Location:	Auburn Blvd - East				
X Coordinate:	-121.30312				
Y Coordinate:	38.69018				
Barrier Area:	Bus Stops and Shelters				
Barrier Type:	Bench Seat Depth				
Code Ref:	ADAAG 4.37.1 and ADA/ABA 903.4

As Built Meas:	1	Quantity:	EACH		
Description:	Bench seat depth not 20" - 24" deep				
As Built Desc:	12-1/2" bench seat depth				
Solution:	Provide min. 1 accessible bench at bench stop				
Bar. Severity:	3 Hindrance	Cost Estimate:	\$775.00	Status:	
Implementation Priority:	1	Facility Function:			
Implementation Phase:		Implementation Date:			
Official Responsible:
