**DRAFT ADA TRANSITION PLAN UPDATE  
NEIGHBORHOOD AREA 4 ARCADE CREEK  
SEPTEMBER 20, 2011**

CITY OF CITRUS HEIGHTS

## Arcade Creek Neighborhood Area

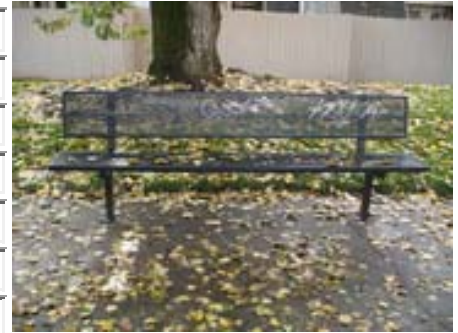
Field Date:	12/6/2010	Report Date:	12/6/2010	Barrier #:	3239B
Location:	Auburn Blvd - East				
X Coordinate:	-121.30312				
Y Coordinate:	38.69018				
Barrier Area:	Bus Stops and Shelters				
Barrier Type:	Bench Back Support				
Code Ref:	ADAAG 4.37.4 and ADA/ABA 903.4

As Built Meas:	1	Quantity:	EACH	
Description:	Bench has no back support of at least 18" high			
As Built Desc:	16-1/2" back support height			
Solution:	Provide min. 1 accessible bench at bench stop or shelter			
Bar. Severity:	3 Hindrance	Cost Estimate:	\$0.00	Status:
Implementation Priority:	1	Facility Function:		
Implementation Phase:		Implementation Date:		
Official Responsible:

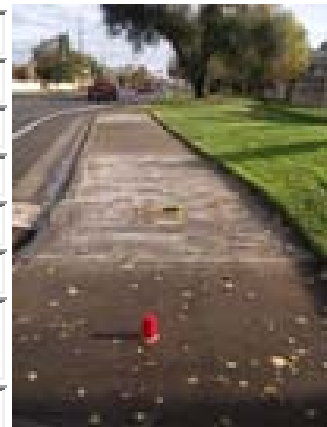
Field Date:	12/6/2010	Report Date:	12/6/2010	Barrier #:	3240
Location:	Auburn Blvd - East				
X Coordinate:	-121.30276				
Y Coordinate:	38.69032				
Barrier Area:	Sidewalks				
Barrier Type:	Cross Slope - Existing (3.1% to 4.0%)				
Code Ref:	CBC 1133B.7.1.3 and ADA/ABA 403.3

As Built Meas:	434	Quantity:	LF	
Description:	Cross slope exceeds 2.0% (3.1% to 4.0%)			
As Built Desc:	3.8% cross slope			
Solution:	Demolish existing and construct new route			
Bar. Severity:	3 Hinderance	Cost Estimate:	\$54,250.00	Status:
Implementation Priority:	1	Facility Function:		
Implementation Phase:		Implementation Date:		
Official Responsible:

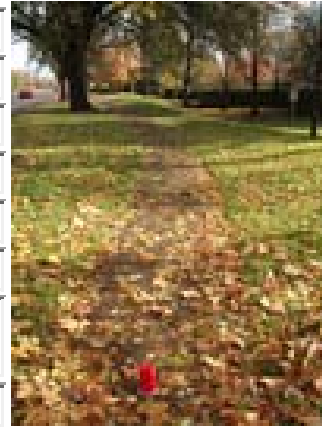
Field Date:	12/6/2010	Report Date:	12/6/2010	Barrier #:	3241
Location:	Auburn Blvd - East				
X Coordinate:	-121.30125				
Y Coordinate:	38.6908				
Barrier Area:	Sidewalks				
Barrier Type:	Cross Slope - Existing (4.1% to 4.9%)				
Code Ref:	CBC 1133B.7.1.3 and ADA/ABA 403.3

As Built Meas:	48	Quantity:	LF	
Description:	Cross slope exceeds 2.0% (4.1% to 4.9%)			
As Built Desc:	4.4% cross slope			
Solution:	Demolish existing and construct new route			
Bar. Severity:	2 Recommended	Cost Estimate:	\$6,000.00	Status:
Implementation Priority:	1	Facility Function:		
Implementation Phase:		Implementation Date:		
Official Responsible:

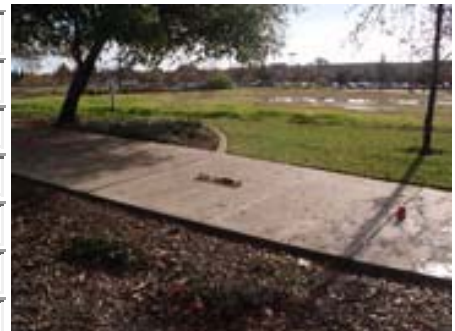
Field Date:	12/6/2010	Report Date:	12/6/2010	Barrier #:	3242
Location:	Auburn Blvd - East				
X Coordinate:	-121.29898				
Y Coordinate:	38.69151				
Barrier Area:	Sidewalks				
Barrier Type:	Running Slope (Existing)				
Code Ref:	CBC 1133B.7.3 and ADA/ABA 403.3

As Built Meas:	16	Quantity:	LF	
Description:	Running slope exceeds 5.0%			
As Built Desc:	7.0% running slope			
Solution:	No remediation where sidewalk sloped as roadway			
Bar. Severity:	5 Technically Infeasible	Cost Estimate:	\$0.00	Status:
Implementation Priority:	1	Facility Function:		
Implementation Phase:		Implementation Date:		
Official Responsible:

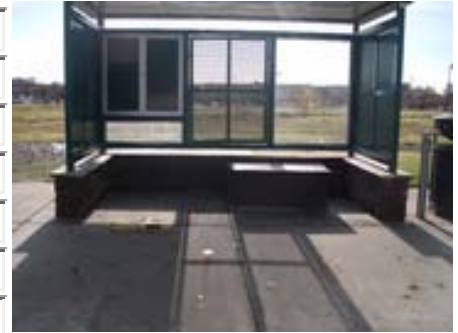
Field Date:	12/6/2010	Report Date:	12/6/2010	Barrier #:	3243A
Location:	Auburn Blvd - East				
X Coordinate:	-121.29792				
Y Coordinate:	38.69191				
Barrier Area:	Bus Stops and Shelters				
Barrier Type:	Cross Slope - Existing (2.1% to 3.0%)				
Code Ref:	CBC 1121B.2.1 and ADAAG 10.2.1(1)

As Built Meas:	8	Quantity:	LF	
Description:	Cross slope at bus pad or shelter exceeds 2.0% (2.1% to 3.0%)			
As Built Desc:	2.4% cross slope			
Solution:	Demolish existing and construct new bus pad or shelter pad			
Bar. Severity:	4 Low Severity	Cost Estimate:	\$1,000.00	Status:
Implementation Priority:	1	Facility Function:		
Implementation Phase:		Implementation Date:		
Official Responsible:

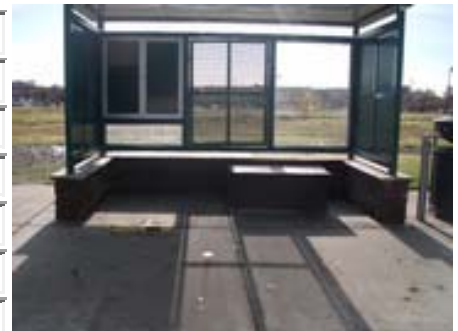
Field Date:	12/6/2010	Report Date:	12/6/2010	Barrier #:	3243B
Location:	Auburn Blvd - East				
X Coordinate:	-121.29792				
Y Coordinate:	38.69191				
Barrier Area:	Bus Stops and Shelters				
Barrier Type:	Bench Seat Height				
Code Ref:	ADAAG 4.37.3* and ADA/ABA 903.4

As Built Meas:	1	Quantity:	EACH	
Description:	Bench seat height not between 17" - 19"			
As Built Desc:	12-1/2" bench seat height			
Solution:	Provide new compliant bench or remount at compliant height where possible			
Bar. Severity:	3 Hindrance	Cost Estimate:	\$775.00	Status:
Implementation Priority:	1	Facility Function:		
Implementation Phase:		Implementation Date:		
Official Responsible:

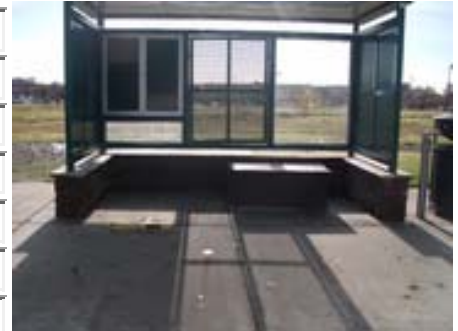
Field Date:	12/6/2010	Report Date:	12/6/2010	Barrier #:	3243C
Location:	Auburn Blvd - East				
X Coordinate:	-121.29792				
Y Coordinate:	38.69191				
Barrier Area:	Bus Stops and Shelters				
Barrier Type:	Bench Back Support				
Code Ref:	ADAAG 4.37.4 and ADA/ABA 903.4

As Built Meas:	1	Quantity:	EACH
Description:	Bench has no back support of at least 18" high		
As Built Desc:	No back support provided		
Solution:	Provide min. 1 accessible bench at bench stop or shelter		
Bar. Severity:	3 Hindrance	Cost Estimate:	\$0.00
Implementation Priority:	1	Facility Function:	
Implementation Phase:		Implementation Date:	
Official Responsible:

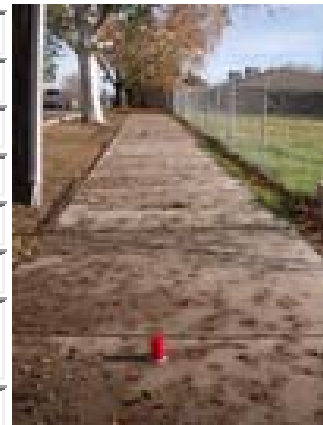
Field Date:	12/6/2010	Report Date:	12/6/2010	Barrier #:	3244
Location:	Auburn Blvd - East				
X Coordinate:	-121.29497				
Y Coordinate:	38.69291				
Barrier Area:	Sidewalks				
Barrier Type:	Cross Slope - Existing (5.0% or more)				
Code Ref:	CBC 1133B.7.1.3 and ADA/ABA 403.3

As Built Meas:	282	Quantity:	LF
Description:	Cross slope exceeds 2.0% (5.0% or more)		
As Built Desc:	5.0% cross slope		
Solution:	Demolish existing and construct new route		
Bar. Severity:	1 Necessary	Cost Estimate:	\$35,250.00
Implementation Priority:	1	Facility Function:	
Implementation Phase:		Implementation Date:	
Official Responsible:

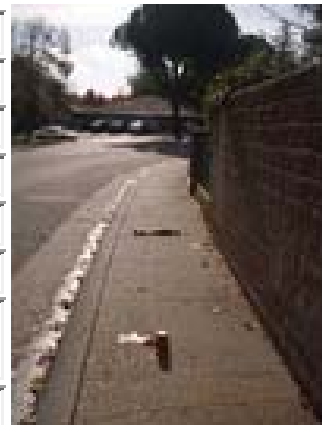
Field Date:	12/6/2010	Report Date:	12/6/2010	Barrier #:	3246
Location:	Chivalry Wy - West				
X Coordinate:	-121.29389				
Y Coordinate:	38.69302				
Barrier Area:	Sidewalks				
Barrier Type:	Cross Slope - Existing (3.1% to 4.0%)				
Code Ref:	CBC 1133B.7.1.3 and ADA/ABA 403.3

As Built Meas:	397	Quantity:	LF		
Description:	Cross slope exceeds 2.0% (3.1% to 4.0%)				
As Built Desc:	3.8% cross slope				
Solution:	Demolish existing and construct new route				
Bar. Severity:	3 Hinderance	Cost Estimate:	\$49,625.00	Status:	
Implementation Priority:	4	Facility Function:			
Implementation Phase:		Implementation Date:			
Official Responsible:

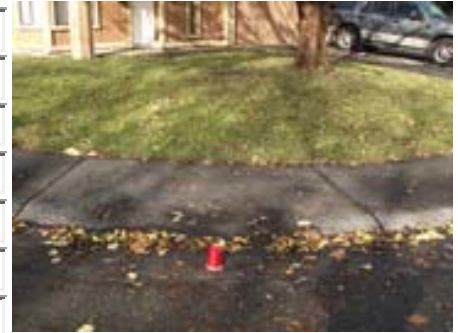
Field Date:	12/6/2010	Report Date:	12/6/2010	Barrier #:	3247
Location:	Chivalry Wy and Chivalry Wy - Corner A				
X Coordinate:	-121.29406				
Y Coordinate:	38.69212				
Barrier Area:	Curb Ramps				
Barrier Type:	No Curb Ramp - Depressed Existing Curb				
Code Ref:	CBC 1127B.5.1 and ADA/ABA 402.2

As Built Meas:	1	Quantity:	EACH	
Description:	No compliant curb cut at corner (intersection)			
As Built Desc:	11.8% running slope at depressed area			
Solution:	Demolish existing and construct curb cut			
Bar. Severity:	1 Necessary	Cost Estimate:	\$2,500.00	Status:
Implementation Priority:	4	Facility Function:		
Implementation Phase:		Implementation Date:		
Official Responsible:

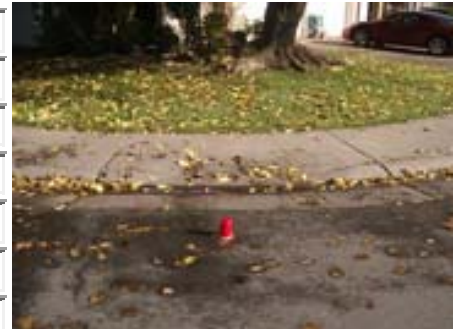
Field Date:	12/6/2010	Report Date:	12/6/2010	Barrier #:	3248
Location:	Chivalry Wy and Chivalry Wy - Corner B				
X Coordinate:	-121.29395				
Y Coordinate:	38.69202				
Barrier Area:	Curb Ramps				
Barrier Type:	No Curb Ramp - Depressed Existing Curb				
Code Ref:	CBC 1127B.5.1 and ADA/ABA 402.2

As Built Meas:	1	Quantity:	EACH	
Description:	No compliant curb cut at corner (intersection)			
As Built Desc:	11.7% running slope at depressed area			
Solution:	Demolish existing and construct curb cut			
Bar. Severity:	1 Necessary	Cost Estimate:	\$2,500.00	Status:
Implementation Priority:	4	Facility Function:		
Implementation Phase:		Implementation Date:		
Official Responsible:

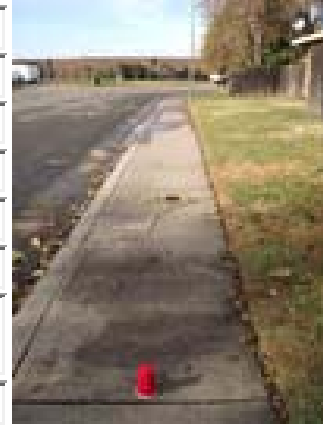
Field Date:	12/6/2010	Report Date:	12/6/2010	Barrier #:	3249
Location:	Chivalry Wy - North				
X Coordinate:	-121.29422				
Y Coordinate:	38.69202				
Barrier Area:	Sidewalks				
Barrier Type:	Cross Slope - Existing (3.1% to 4.0%)				
Code Ref:	CBC 1133B.7.1.3 and ADA/ABA 403.3

As Built Meas:	175	Quantity:	LF
Description:	Cross slope exceeds 2.0% (3.1% to 4.0%)		
As Built Desc:	3.1% cross slope		
Solution:	Demolish existing and construct new route		
Bar. Severity:	3 Hinderance	Cost Estimate:	\$21,875.00
Implementation Priority:	4	Facility Function:	
Implementation Phase:		Implementation Date:	
Official Responsible:

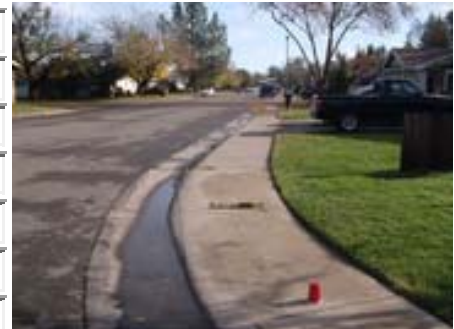
Field Date:	12/6/2010	Report Date:	12/6/2010	Barrier #:	3250
Location:	Chivalry Wy - South				
X Coordinate:	-121.29452				
Y Coordinate:	38.69189				
Barrier Area:	Sidewalks				
Barrier Type:	Cross Slope - Existing (3.1% to 4.0%)				
Code Ref:	CBC 1133B.7.1.3 and ADA/ABA 403.3

As Built Meas:	172	Quantity:	LF
Description:	Cross slope exceeds 2.0% (3.1% to 4.0%)		
As Built Desc:	3.8% cross slope		
Solution:	Demolish existing and construct new route		
Bar. Severity:	3 Hinderance	Cost Estimate:	\$21,500.00
Implementation Priority:	4	Facility Function:	
Implementation Phase:		Implementation Date:	
Official Responsible:

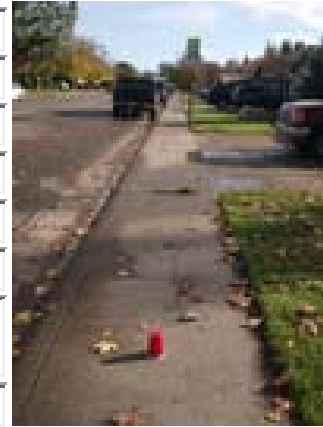
Field Date:	12/6/2010	Report Date:	12/6/2010	Barrier #:	3251
Location:	Gallant Cir - South				
X Coordinate:	-121.29395				
Y Coordinate:	38.69185				
Barrier Area:	Sidewalks				
Barrier Type:	Cross Slope - Existing (3.1% to 4.0%)				
Code Ref:	CBC 1133B.7.1.3 and ADA/ABA 403.3

As Built Meas:	672	Quantity:	LF	
Description:	Cross slope exceeds 2.0% (3.1% to 4.0%)			
As Built Desc:	3.7% cross slope			
Solution:	Demolish existing and construct new route			
Bar. Severity:	3 Hinderance	Cost Estimate:	\$84,000.00	Status:
Implementation Priority:	4	Facility Function:		
Implementation Phase:		Implementation Date:		
Official Responsible:

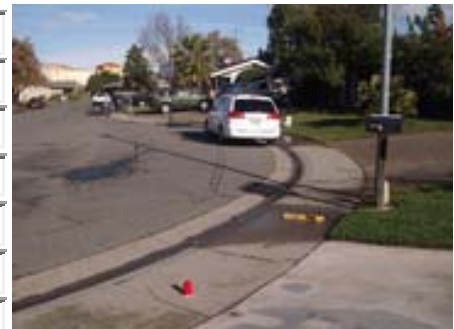
Field Date:	12/6/2010	Report Date:	12/6/2010	Barrier #:	3252
Location:	Gallant Cir - East				
X Coordinate:	-121.29155				
Y Coordinate:	38.69183				
Barrier Area:	Sidewalks				
Barrier Type:	Cross Slope - Existing (5.0% or more)				
Code Ref:	CBC 1133B.7.1.3 and ADA/ABA 403.3

As Built Meas:	251	Quantity:	LF	
Description:	Cross slope exceeds 2.0% (5.0% or more)			
As Built Desc:	6.6% cross slope			
Solution:	Demolish existing and construct new route			
Bar. Severity:	1 Necessary	Cost Estimate:	\$31,375.00	Status:
Implementation Priority:	4	Facility Function:		
Implementation Phase:		Implementation Date:		
Official Responsible:

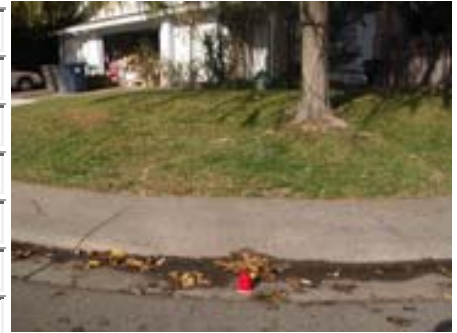
Field Date:	12/6/2010	Report Date:	12/6/2010	Barrier #:	3253
Location:	Gallant Cir and Sutro Ct - Corner A				
X Coordinate:	-121.29264				
Y Coordinate:	38.69273				
Barrier Area:	Curb Ramps				
Barrier Type:	No Curb Ramp - Depressed Existing Curb				
Code Ref:	CBC 1127B.5.1 and ADA/ABA 402.2

As Built Meas:	1	Quantity:	EACH
Description:	No compliant curb cut at corner (intersection)		
As Built Desc:	14.1% running slope at depressed area		
Solution:	Demolish existing and construct curb cut		
Bar. Severity:	1 Necessary	Cost Estimate:	\$2,500.00
Implementation Priority:	4	Facility Function:	
Implementation Phase:		Implementation Date:	
Official Responsible:

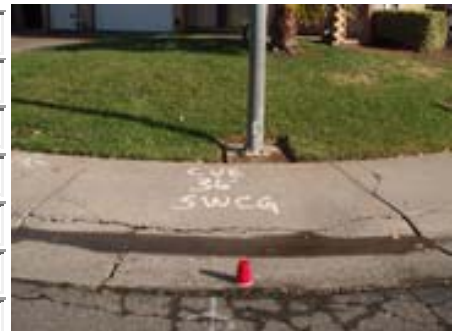
Field Date:	12/6/2010	Report Date:	12/6/2010	Barrier #:	3254
Location:	Gallant Cir and Sutro Ct - Corner B				
X Coordinate:	-121.29283				
Y Coordinate:	38.69272				
Barrier Area:	Curb Ramps				
Barrier Type:	No Curb Ramp - Depressed Existing Curb				
Code Ref:	CBC 1127B.5.1 and ADA/ABA 402.2

As Built Meas:	1	Quantity:	EACH
Description:	No compliant curb cut at corner (intersection)		
As Built Desc:	13.9% running slope at depressed area		
Solution:	Demolish existing and construct curb cut		
Bar. Severity:	1 Necessary	Cost Estimate:	\$2,500.00
Implementation Priority:	4	Facility Function:	
Implementation Phase:		Implementation Date:	
Official Responsible:

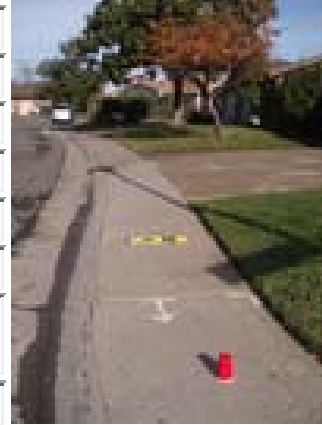
Field Date:	12/6/2010	Report Date:	12/6/2010	Barrier #:	3255
Location:	Sutro Ct - East				
X Coordinate:	-121.29269				
Y Coordinate:	38.69279				
Barrier Area:	Sidewalks				
Barrier Type:	Cross Slope - Existing (3.1% to 4.0%)				
Code Ref:	CBC 1133B.7.1.3 and ADA/ABA 403.3

As Built Meas:	213	Quantity:	LF	
Description:	Cross slope exceeds 2.0% (3.1% to 4.0%)			
As Built Desc:	3.8% cross slope			
Solution:	Demolish existing and construct new route			
Bar. Severity:	3 Hinderance	Cost Estimate:	\$26,625.00	Status:
Implementation Priority:	4	Facility Function:		
Implementation Phase:		Implementation Date:		
Official Responsible:

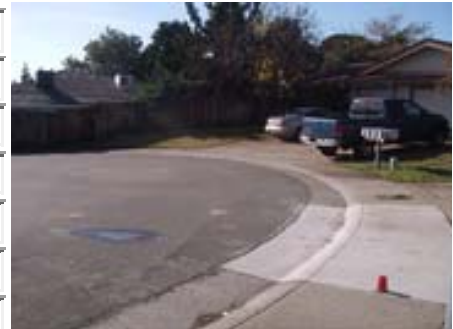
Field Date:	12/6/2010	Report Date:	12/6/2010	Barrier #:	3256
Location:	Sutro Ct - West				
X Coordinate:	-121.29298				
Y Coordinate:	38.69323				
Barrier Area:	Sidewalks				
Barrier Type:	Cross Slope - Existing (4.1% to 4.9%)				
Code Ref:	CBC 1133B.7.1.3 and ADA/ABA 403.3

As Built Meas:	216	Quantity:	LF	
Description:	Cross slope exceeds 2.0% (4.1% to 4.9%)			
As Built Desc:	4.7% cross slope			
Solution:	Demolish existing and construct new route			
Bar. Severity:	2 Recommended	Cost Estimate:	\$27,000.00	Status:
Implementation Priority:	4	Facility Function:		
Implementation Phase:		Implementation Date:		
Official Responsible:

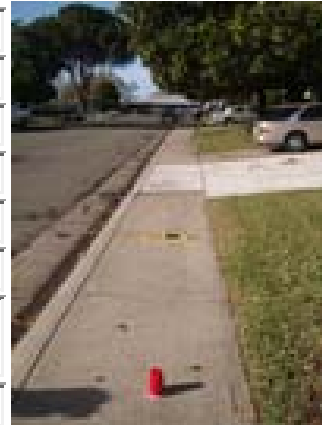
Field Date:	12/6/2010	Report Date:	12/6/2010	Barrier #:	3257
Location:	Gallant Cir - North				
X Coordinate:	-121.29292				
Y Coordinate:	38.69271				
Barrier Area:	Sidewalks				
Barrier Type:	Cross Slope - Existing (5.0% or more)				
Code Ref:	CBC 1133B.7.1.3 and ADA/ABA 403.3

As Built Meas:	225	Quantity:	LF	
Description:	Cross slope exceeds 2.0% (5.0% or more)			
As Built Desc:	6.3% cross slope			
Solution:	Demolish existing and construct new route			
Bar. Severity:	1 Necessary	Cost Estimate:	\$28,125.00	Status:
Implementation Priority:	4	Facility Function:		
Implementation Phase:		Implementation Date:		
Official Responsible:

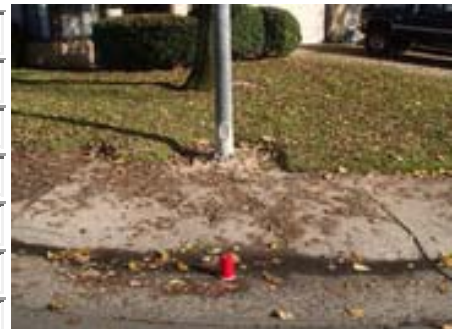
Field Date:	12/6/2010	Report Date:	12/6/2010	Barrier #:	3258
Location:	Gallant Cir and Chivalry Wy - Corner B				
X Coordinate:	-121.29373				
Y Coordinate:	38.69274				
Barrier Area:	Curb Ramps				
Barrier Type:	No Curb Ramp - Depressed Existing Curb				
Code Ref:	CBC 1127B.5.1 and ADA/ABA 402.2

As Built Meas:	1	Quantity:	EACH	
Description:	No compliant curb cut at corner (intersection)			
As Built Desc:	16.3% running slope at depressed area			
Solution:	Demolish existing and construct curb cut			
Bar. Severity:	1 Necessary	Cost Estimate:	\$2,500.00	Status:
Implementation Priority:	4	Facility Function:		
Implementation Phase:		Implementation Date:		
Official Responsible:

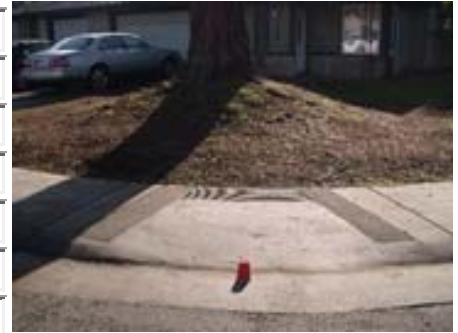
Field Date:	12/6/2010	Report Date:	12/6/2010	Barrier #:	3259A
Location:	Gallant Cir and Chivalry Wy - Corner C				
X Coordinate:	-121.29382				
Y Coordinate:	38.6926				
Barrier Area:	Curb Ramps				
Barrier Type:	12" Grooves - Existing (3.1% to 4.0%)				
Code Ref:	CBC 1127B.5.6

As Built Meas:	1	Quantity:	EACH	
Description:	12" grooves at top of curb ramp are not level (3.1% to 4.0%)			
As Built Desc:	3.8% at 12" grooves			
Solution:	Demolish existing and construct new curb ramp			
Bar. Severity:	3 Hindrance	Cost Estimate:	\$2,500.00	Status:
Implementation Priority:	4	Facility Function:		
Implementation Phase:		Implementation Date:		
Official Responsible:

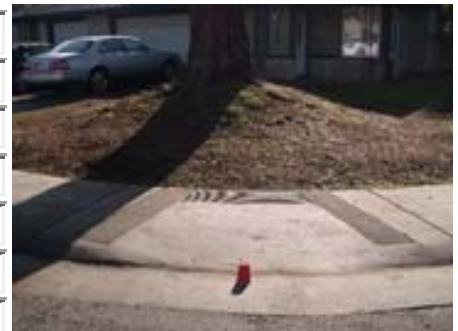
Field Date:	12/6/2010	Report Date:	12/6/2010	Barrier #:	3259B
Location:	Gallant Cir and Chivalry Wy - Corner C				
X Coordinate:	-121.29382				
Y Coordinate:	38.6926				
Barrier Area:	Curb Ramps				
Barrier Type:	Parallel Ramp Landing - New Construction				
Code Ref:	CBC 1127B.5.4 and ADA/ABA 406.4

As Built Meas:	1	Quantity:	EACH	
Description:	Curb ramp top landing not min. 48" deep			
As Built Desc:	4.6% landing slope			
Solution:	Demolish existing and construct new transition			
Bar. Severity:	1 Necessary	Cost Estimate:	\$0.00	Status:
Implementation Priority:	4	Facility Function:		
Implementation Phase:		Implementation Date:		
Official Responsible:

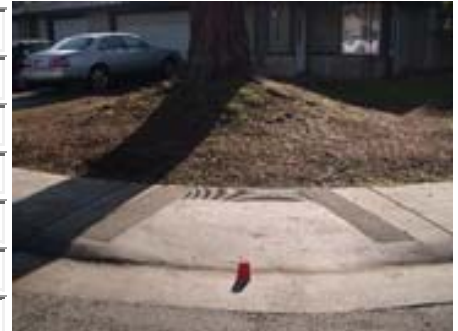
Field Date:	12/6/2010	Report Date:	12/6/2010	Barrier #:	3259C
Location:	Gallant Cir and Chivalry Wy - Corner C				
X Coordinate:	-121.29382				
Y Coordinate:	38.6926				
Barrier Area:	Curb Ramps				
Barrier Type:	Detectable Warnings - Truncated Domes				
Code Ref:	CBC 1127B.5.7 and ADA/ABA 705.1.3

As Built Meas:	1	Quantity:	EACH
Description:	No truncated domes provided at curb ramp		
As Built Desc:	No detectable warnings at curb ramp		
Solution:	Provide compliant truncated domes		
Bar. Severity:	2 Recommended	Cost Estimate:	\$0.00
Implementation Priority:	4	Facility Function:	
Implementation Phase:		Implementation Date:	
Official Responsible:

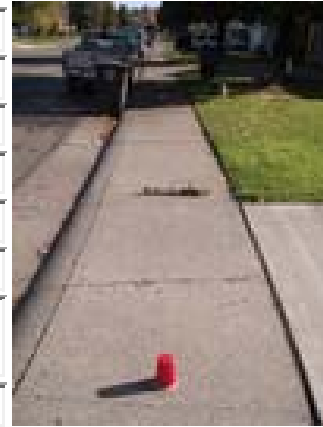
Field Date:	12/6/2010	Report Date:	12/6/2010	Barrier #:	3260
Location:	Gallant Cir - South				
X Coordinate:	-121.29362				
Y Coordinate:	38.6926				
Barrier Area:	Sidewalks				
Barrier Type:	Cross Slope - Existing (4.1% to 4.9%)				
Code Ref:	CBC 1133B.7.1.3 and ADA/ABA 403.3

As Built Meas:	553	Quantity:	LF	
Description:	Cross slope exceeds 2.0% (4.1% to 4.9%)			
As Built Desc:	4.6% cross slope			
Solution:	Demolish existing and construct new route			
Bar. Severity:	2 Recommended	Cost Estimate:	\$69,125.00	Status:
Implementation Priority:	4	Facility Function:		
Implementation Phase:		Implementation Date:		
Official Responsible:

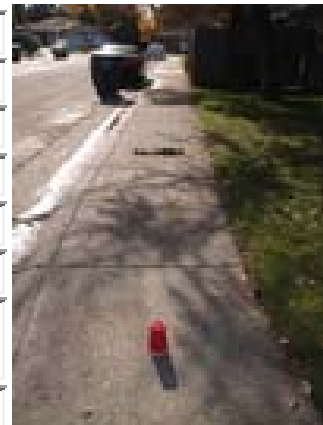
Field Date:	12/6/2010	Report Date:	12/6/2010	Barrier #:	3261
Location:	Gallant Cir - West				
X Coordinate:	-121.29166				
Y Coordinate:	38.69244				
Barrier Area:	Sidewalks				
Barrier Type:	Cross Slope - Existing (4.1% to 4.9%)				
Code Ref:	CBC 1133B.7.1.3 and ADA/ABA 403.3

As Built Meas:	186	Quantity:	LF	
Description:	Cross slope exceeds 2.0% (4.1% to 4.9%)			
As Built Desc:	4.9% cross slope			
Solution:	Demolish existing and construct new route			
Bar. Severity:	2 Recommended	Cost Estimate:	\$23,250.00	Status:
Implementation Priority:	4	Facility Function:		
Implementation Phase:		Implementation Date:		
Official Responsible:

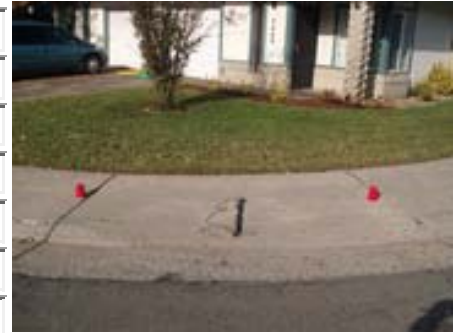
Field Date:	12/6/2010	Report Date:	12/6/2010	Barrier #:	3262
Location:	Gallant Cir - West				
X Coordinate:	-121.29167				
Y Coordinate:	38.69201				
Barrier Area:	Sidewalks				
Barrier Type:	Elbow in Sidewalk - Cross Slope (5.0% or more)				
Code Ref:	CBC 1133B.7.1.3 and ADA/ABA 403.3

As Built Meas:	6	Quantity:	LF		
Description:	Cross slope at elbow exceeds 2.0% (5.0% or more)				
As Built Desc:	14.2% cross slope				
Solution:	Demolish existing and construct new sidewalk without curb ramp				
Bar. Severity:	1 Necessary	Cost Estimate:	\$750.00	Status:	
Implementation Priority:	4	Facility Function:			
Implementation Phase:		Implementation Date:			
Official Responsible:

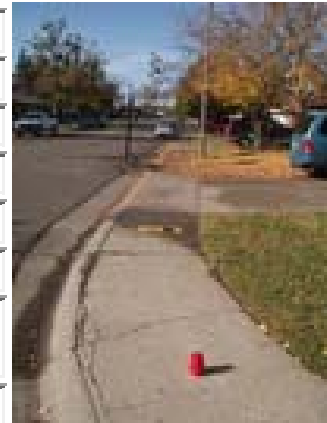
Field Date:	12/6/2010	Report Date:	12/6/2010	Barrier #:	3263
Location:	Gallant Cir - North				
X Coordinate:	-121.2917				
Y Coordinate:	38.69195				
Barrier Area:	Sidewalks				
Barrier Type:	Cross Slope - Existing (5.0% or more)				
Code Ref:	CBC 1133B.7.1.3 and ADA/ABA 403.3

As Built Meas:	628	Quantity:	LF		
Description:	Cross slope exceeds 2.0% (5.0% or more)				
As Built Desc:	5.2% cross slope				
Solution:	Demolish existing and construct new route				
Bar. Severity:	1 Necessary	Cost Estimate:	\$78,500.00	Status:	
Implementation Priority:	4	Facility Function:			
Implementation Phase:		Implementation Date:			
Official Responsible:

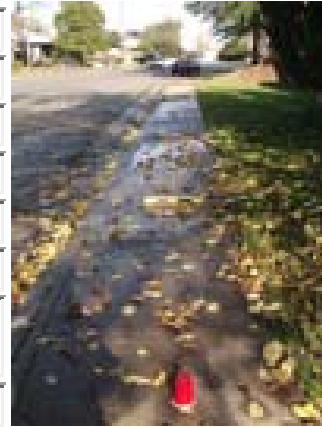
Field Date:	12/6/2010	Report Date:	12/6/2010	Barrier #:	3264
Location:	Chivalry Wy - East				
X Coordinate:	-121.29389				
Y Coordinate:	38.6921				
Barrier Area:	Sidewalks				
Barrier Type:	Cross Slope - Existing (3.1% to 4.0%)				
Code Ref:	CBC 1133B.7.1.3 and ADA/ABA 403.3

As Built Meas:	195	Quantity:	LF	
Description:	Cross slope exceeds 2.0% (3.1% to 4.0%)			
As Built Desc:	3.8% cross slope			
Solution:	Demolish existing and construct new route			
Bar. Severity:	3 Hinderance	Cost Estimate:	\$24,375.00	Status:
Implementation Priority:	4	Facility Function:		
Implementation Phase:		Implementation Date:		
Official Responsible:

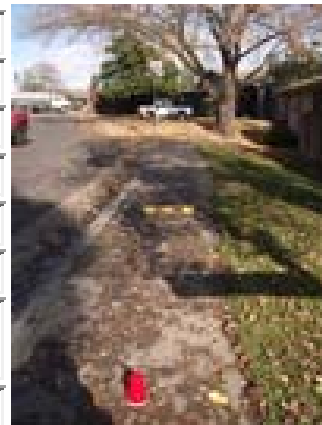
Field Date:	12/6/2010	Report Date:	12/6/2010	Barrier #:	3265
Location:	Chivalry Wy - East				
X Coordinate:	-121.29392				
Y Coordinate:	38.69225				
Barrier Area:	Sidewalks				
Barrier Type:	Cross Slope - Existing (3.1% to 4.0%)				
Code Ref:	CBC 1133B.7.1.3 and ADA/ABA 403.3

As Built Meas:	160	Quantity:	LF	
Description:	Cross slope exceeds 2.0% (3.1% to 4.0%)			
As Built Desc:	3.5% cross slope			
Solution:	Demolish existing and construct new route			
Bar. Severity:	3 Hinderance	Cost Estimate:	\$20,000.00	Status:
Implementation Priority:	4	Facility Function:		
Implementation Phase:		Implementation Date:		
Official Responsible:

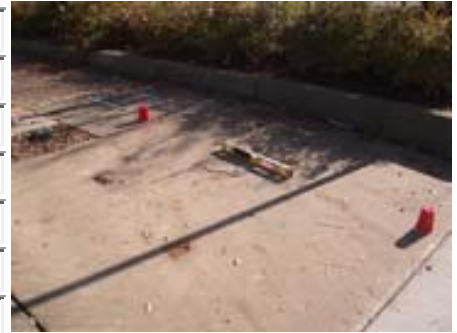
Field Date:	12/6/2010	Report Date:	12/6/2010	Barrier #:	3266
Location:	Auburn Blvd - South				
X Coordinate:	-121.29125				
Y Coordinate:	38.69415				
Barrier Area:	Sidewalks				
Barrier Type:	Running Slope (Existing)				
Code Ref:	CBC 1133B.7.3 and ADA/ABA 403.3

As Built Meas:	8	Quantity:	LF
Description:	Running slope exceeds 5.0%		
As Built Desc:	7.0% running slope		
Solution:	No remediation where sidewalk sloped as roadway		
Bar. Severity:	5 Technically Infeasible	Cost Estimate:	\$0.00
Implementation Priority:	1	Facility Function:	
Implementation Phase:		Implementation Date:	
Official Responsible:

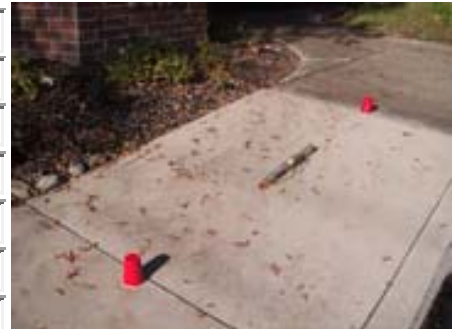
Field Date:	12/6/2010	Report Date:	12/6/2010	Barrier #:	3267
Location:	Sylvan Rd - West				
X Coordinate:	-121.29047				
Y Coordinate:	38.69303				
Barrier Area:	Sidewalks				
Barrier Type:	Running Slope (Existing)				
Code Ref:	CBC 1133B.7.3 and ADA/ABA 403.3

As Built Meas:	16	Quantity:	LF
Description:	Running slope exceeds 5.0%		
As Built Desc:	8.9% running slope		
Solution:	No remediation where sidewalk sloped as roadway		
Bar. Severity:	5 Technically Infeasible	Cost Estimate:	\$0.00
Implementation Priority:	4	Facility Function:	
Implementation Phase:		Implementation Date:	
Official Responsible:

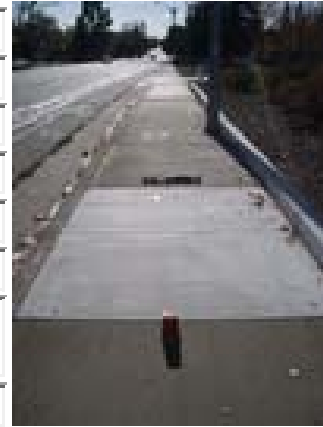
Field Date:	12/6/2010	Report Date:	12/6/2010	Barrier #:	3268
Location:	Sylvan Rd - West				
X Coordinate:	-121.29042				
Y Coordinate:	38.69215				
Barrier Area:	Sidewalks				
Barrier Type:	Cross Slope - Existing (2.1% to 3.0%)				
Code Ref:	CBC 1133B.7.1.3 and ADA/ABA 403.3

As Built Meas:	62	Quantity:	LF	
Description:	Cross slope exceeds 2.0% (2.1% to 3.0%)			
As Built Desc:	2.9% cross slope			
Solution:	Low severity barrier - no remediation recommended			
Bar. Severity:	4 Low Severity	Cost Estimate:	\$0.00	Status:
Implementation Priority:	4	Facility Function:		
Implementation Phase:		Implementation Date:		
Official Responsible:

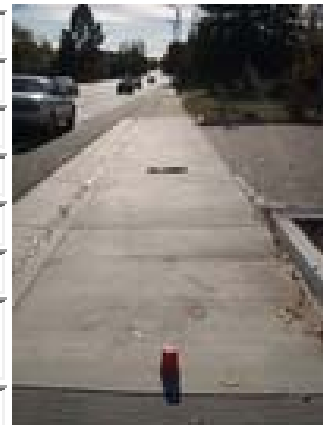
Field Date:	12/6/2010	Report Date:	12/6/2010	Barrier #:	3269
Location:	Sylvan Rd - West				
X Coordinate:	-121.29042				
Y Coordinate:	38.69191				
Barrier Area:	Sidewalks				
Barrier Type:	Driveway - Existing (4.1% to 4.9%)				
Code Ref:	CBC 1133B.7.1.3 and ADA/ABA 403.3

As Built Meas:	50	Quantity:	LF	
Description:	Driveway cross slope exceeds 2.0% (4.1% to 4.9%)			
As Built Desc:	4.2% cross slope			
Solution:	Provide min. 48" wide level walkway through driveway			
Bar. Severity:	3 Hinderance	Cost Estimate:	\$6,250.00	Status:
Implementation Priority:	4	Facility Function:		
Implementation Phase:		Implementation Date:		
Official Responsible:

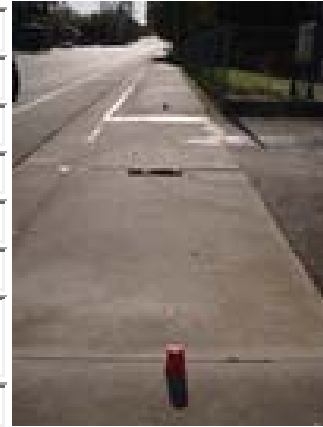
Field Date:	12/6/2010	Report Date:	12/6/2010	Barrier #:	3270
Location:	Sylvan Rd - West				
X Coordinate:	-121.2904				
Y Coordinate:	38.69138				
Barrier Area:	Sidewalks				
Barrier Type:	Driveway - Existing (2.1% to 3.0%)				
Code Ref:	CBC 1133B.7.1.3 and ADA/ABA 403.3

As Built Meas:	28	Quantity:	LF	
Description:	Driveway cross slope exceeds 2.0% (2.1% to 3.0%)			
As Built Desc:	2.6% cross slope, 14.8% running slope			
Solution:	Provide min. 48" wide level walkway through driveway			
Bar. Severity:	1 Necessary	Cost Estimate:	\$3,500.00	Status:
Implementation Priority:	4	Facility Function:		
Implementation Phase:		Implementation Date:		
Official Responsible:

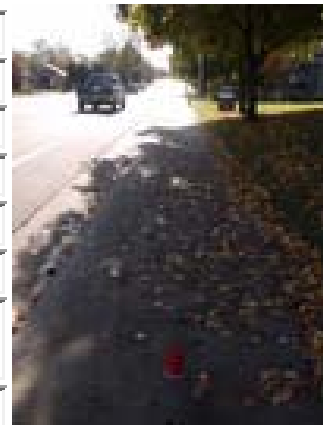
Field Date:	12/6/2010	Report Date:	12/6/2010	Barrier #:	3271
Location:	Sylvan Rd - West				
X Coordinate:	-121.29042				
Y Coordinate:	38.69101				
Barrier Area:	Sidewalks				
Barrier Type:	Cross Slope - Existing (3.1% to 4.0%)				
Code Ref:	CBC 1133B.7.1.3 and ADA/ABA 403.3

As Built Meas:	106	Quantity:	LF	
Description:	Cross slope exceeds 2.0% (3.1% to 4.0%)			
As Built Desc:	3.8% cross slope			
Solution:	Demolish existing and construct new route			
Bar. Severity:	3 Hinderance	Cost Estimate:	\$13,250.00	Status:
Implementation Priority:	4	Facility Function:		
Implementation Phase:		Implementation Date:		
Official Responsible:

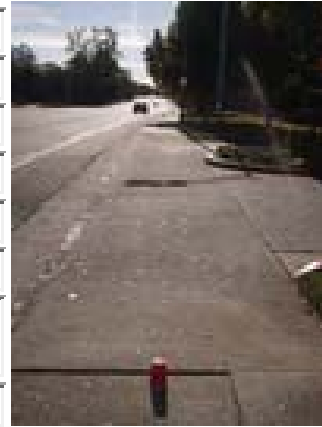
Field Date: 12/6/2010 Report Date: 12/6/2010 Barrier #: 3272  
Location: Sylvan Rd - West  
X Coordinate: -121.29045  
Y Coordinate: 38.69068  
Barrier Area: Sidewalks  
Barrier Type: Driveway - Existing (5.0% or more)  
Code Ref: CBC 1133B.7.1.3 and ADA/ABA 403.3

As Built Meas: 58 Quantity: LF  
Description: Driveway cross slope exceeds 2.0% (5.0% or more)  
As Built Desc: 5.8% cross slope  
Solution: Provide min. 48" wide level walkway through driveway  
Bar. Severity: 4 Low Severity Cost Estimate: \$7,250.00 Status:  
Implementation Priority: 4 Facility Function:  
Implementation Phase: Implementation Date:  
Official Responsible:

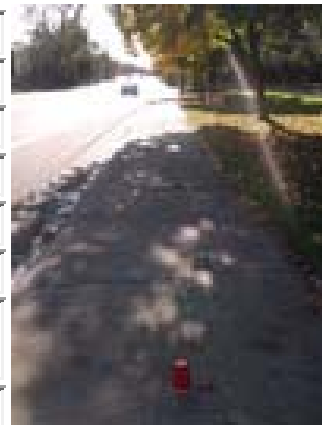
Field Date: 12/6/2010 Report Date: 12/6/2010 Barrier #: 3273  
Location: Sylvan Rd - West  
X Coordinate: -121.29046  
Y Coordinate: 38.69047  
Barrier Area: Sidewalks  
Barrier Type: Cross Slope - Existing (5.0% or more)  
Code Ref: CBC 1133B.7.1.3 and ADA/ABA 403.3

As Built Meas: 391 Quantity: LF  
Description: Cross slope exceeds 2.0% (5.0% or more)  
As Built Desc: 5.3% cross slope  
Solution: Demolish existing and construct new route  
Bar. Severity: 1 Necessary Cost Estimate: \$48,875.00 Status:  
Implementation Priority: 4 Facility Function:  
Implementation Phase: Implementation Date:  
Official Responsible:

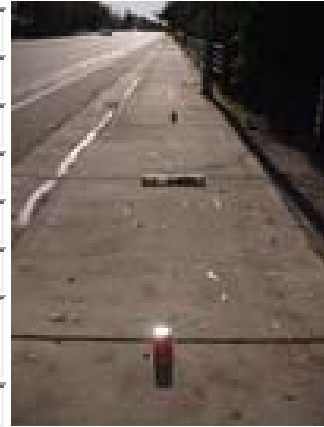
Field Date: 12/6/2010 Report Date: 12/6/2010 Barrier #: 3274  
 Location: Sylvan Rd - West  
 X Coordinate: -121.29048  
 Y Coordinate: 38.68913  
 Barrier Area: Sidewalks  
 Barrier Type: Driveway - Existing (3.1% to 4.0%)  
 Code Ref: CBC 1133B.7.1.3 and ADA/ABA 403.3

As Built Meas: 64 Quantity: LF  
 Description: Driveway cross slope exceeds 2.0% (3.1% to 4.0%)  
 As Built Desc: 4.0% cross slope  
 Solution: Provide min. 48" wide level walkway through driveway  
 Bar. Severity: 2 Recommended Cost Estimate: \$8,000.00 Status:  
 Implementation Priority: 4 Facility Function:  
 Implementation Phase: Implementation Date:  
 Official Responsible:

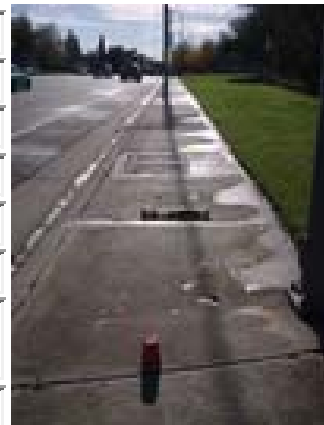
Field Date: 12/6/2010 Report Date: 12/6/2010 Barrier #: 3275  
 Location: Sylvan Rd - West  
 X Coordinate: -121.29049  
 Y Coordinate: 38.68784  
 Barrier Area: Sidewalks  
 Barrier Type: Cross Slope - Existing (4.1% to 4.9%)  
 Code Ref: CBC 1133B.7.1.3 and ADA/ABA 403.3

As Built Meas: 244 Quantity: LF  
 Description: Cross slope exceeds 2.0% (4.1% to 4.9%)  
 As Built Desc: 4.1% cross slope  
 Solution: Demolish existing and construct new route  
 Bar. Severity: 2 Recommended Cost Estimate: \$30,500.00 Status:  
 Implementation Priority: 4 Facility Function:  
 Implementation Phase: Implementation Date:  
 Official Responsible:

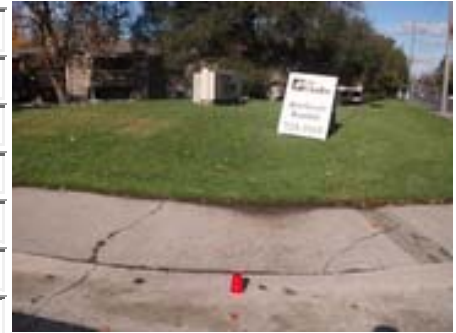
Field Date:	12/6/2010	Report Date:	12/6/2010	Barrier #:	3276
Location:	Sylvan Rd and Oaks Apartment Entrance - Corner A				
X Coordinate:	-121.29054				
Y Coordinate:	38.68717				
Barrier Area:	Curb Ramps				
Barrier Type:	Detectable Warnings - Truncated Domes				
Code Ref:	CBC 1127B.5.7 and ADA/ABA 705.1.3

As Built Meas:	1	Quantity:	EACH	
Description:	No truncated domes provided at curb ramp			
As Built Desc:	No detectable warnings at curb ramp			
Solution:	Provide compliant truncated domes			
Bar. Severity:	2 Recommended	Cost Estimate:	\$1,400.00	Status:
Implementation Priority:	4	Facility Function:		
Implementation Phase:		Implementation Date:		
Official Responsible:

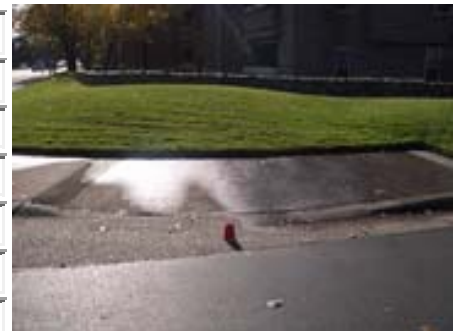
Field Date:	12/6/2010	Report Date:	12/6/2010	Barrier #:	3277
Location:	Sylvan Rd and Oaks Apartment Entrance - Corner D				
X Coordinate:	-121.29057				
Y Coordinate:	38.68703				
Barrier Area:	Curb Ramps				
Barrier Type:	Detectable Warnings - Truncated Domes				
Code Ref:	CBC 1127B.5.7 and ADA/ABA 705.1.3

As Built Meas:	1	Quantity:	EACH	
Description:	No truncated domes provided at curb ramp			
As Built Desc:	No detectable warnings at curb ramp			
Solution:	Provide compliant truncated domes			
Bar. Severity:	2 Recommended	Cost Estimate:	\$1,400.00	Status:
Implementation Priority:	4	Facility Function:		
Implementation Phase:		Implementation Date:		
Official Responsible:

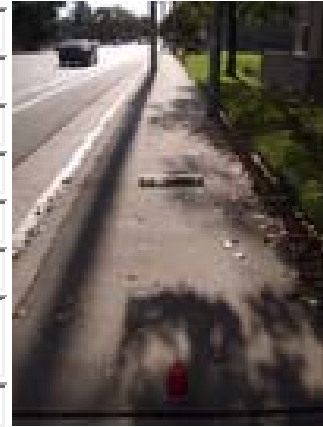
Field Date:	12/6/2010	Report Date:	12/6/2010	Barrier #:	3278
Location:	Sylvan Rd - West				
X Coordinate:	-121.29048				
Y Coordinate:	38.6866				
Barrier Area:	Sidewalks				
Barrier Type:	Cross Slope - Existing (3.1% to 4.0%)				
Code Ref:	CBC 1133B.7.1.3 and ADA/ABA 403.3

As Built Meas:	378	Quantity:	LF		
Description:	Cross slope exceeds 2.0% (3.1% to 4.0%)				
As Built Desc:	3.8% cross slope				
Solution:	Demolish existing and construct new route				
Bar. Severity:	3 Hinderance	Cost Estimate:	\$47,250.00	Status:	
Implementation Priority:	4	Facility Function:			
Implementation Phase:		Implementation Date:			
Official Responsible:

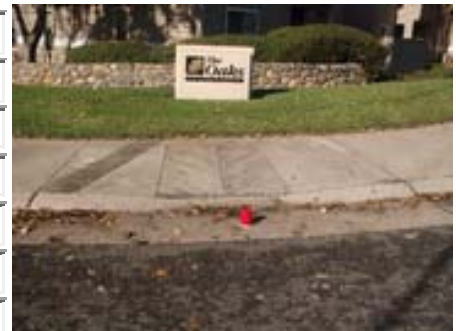
Field Date:	12/6/2010	Report Date:	12/6/2010	Barrier #:	3279A
Location:	Sylvan Rd and Woodside Dr - Corner A				
X Coordinate:	-121.29049				
Y Coordinate:	38.68566				
Barrier Area:	Curb Ramps				
Barrier Type:	12" Grooves - Existing (>5.0%)				
Code Ref:	CBC 1127B.5.6

As Built Meas:	1	Quantity:	EACH		
Description:	12" grooves at top of curb ramp are not level (>5.0%)				
As Built Desc:	9.1% at 12" grooves				
Solution:	Demolish existing and construct new curb ramp				
Bar. Severity:	1 Necessary	Cost Estimate:	\$2,500.00	Status:	
Implementation Priority:	4	Facility Function:			
Implementation Phase:		Implementation Date:			
Official Responsible:

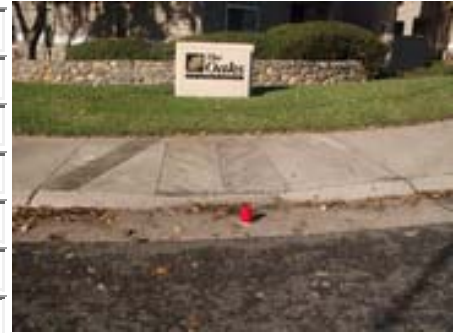
Field Date:	12/6/2010	Report Date:	12/6/2010	Barrier #:	3279B
Location:	Sylvan Rd and Woodside Dr - Corner A				
X Coordinate:	-121.29049				
Y Coordinate:	38.68566				
Barrier Area:	Curb Ramps				
Barrier Type:	Detectable Warnings - Truncated Domes				
Code Ref:	CBC 1127B.5.7 and ADA/ABA 705.1.3

As Built Meas:	1	Quantity:	EACH		
Description:	No truncated domes provided at curb ramp				
As Built Desc:	No detectable warnings at curb ramp				
Solution:	Provide compliant truncated domes				
Bar. Severity:	2 Recommended	Cost Estimate:	\$0.00	Status:	
Implementation Priority:	4	Facility Function:			
Implementation Phase:		Implementation Date:			
Official Responsible:

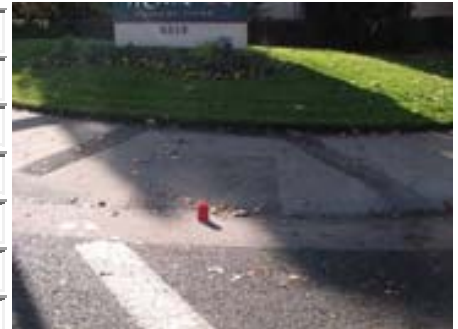
Field Date:	12/6/2010	Report Date:	12/6/2010	Barrier #:	3280A
Location:	Sylvan Rd and Woodside Dr - Corner D				
X Coordinate:	-121.29052				
Y Coordinate:	38.68545				
Barrier Area:	Curb Ramps				
Barrier Type:	12" Grooves - Existing (>5.0%)				
Code Ref:	CBC 1127B.5.6

As Built Meas:	1	Quantity:	EACH		
Description:	12" grooves at top of curb ramp are not level (>5.0%)				
As Built Desc:	8.1% at 12" grooves				
Solution:	Demolish existing and construct new curb ramp				
Bar. Severity:	1 Necessary	Cost Estimate:	\$2,500.00	Status:	
Implementation Priority:	4	Facility Function:			
Implementation Phase:		Implementation Date:			
Official Responsible:

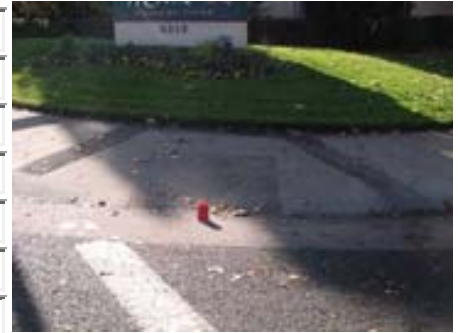
Field Date:	12/6/2010	Report Date:	12/6/2010	Barrier #:	3280B
Location:	Sylvan Rd and Woodside Dr - Corner D				
X Coordinate:	-121.29052				
Y Coordinate:	38.68545				
Barrier Area:	Curb Ramps				
Barrier Type:	Detectable Warnings - Truncated Domes				
Code Ref:	CBC 1127B.5.7 and ADA/ABA 705.1.3

As Built Meas:	1	Quantity:	EACH		
Description:	No truncated domes provided at curb ramp				
As Built Desc:	No detectable warnings at curb ramp				
Solution:	Provide compliant truncated domes				
Bar. Severity:	2 Recommended	Cost Estimate:	\$0.00	Status:	
Implementation Priority:	4	Facility Function:			
Implementation Phase:		Implementation Date:			
Official Responsible:

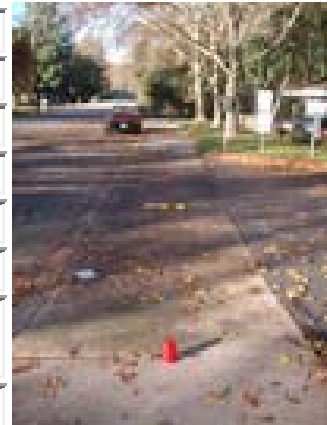
Field Date:	12/7/2010	Report Date:	12/7/2010	Barrier #:	3281
Location:	Woodside Dr - North				
X Coordinate:	-121.29096				
Y Coordinate:	38.68567				
Barrier Area:	Sidewalks				
Barrier Type:	Driveway - Existing (2.1% to 3.0%)				
Code Ref:	CBC 1133B.7.1.3 and ADA/ABA 403.3

As Built Meas:	38	Quantity:	LF		
Description:	Driveway cross slope exceeds 2.0% (2.1% to 3.0%)				
As Built Desc:	3.0% cross slope, 11.4% running slope				
Solution:	Provide min. 48" wide level walkway through driveway				
Bar. Severity:	1 Necessary	Cost Estimate:	\$4,750.00	Status:	
Implementation Priority:	4	Facility Function:			
Implementation Phase:		Implementation Date:			
Official Responsible:

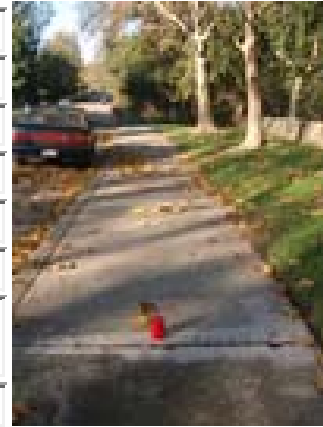
Field Date:	12/7/2010	Report Date:	12/7/2010	Barrier #:	3282
Location:	Woodside Dr - North				
X Coordinate:	-121.29109				
Y Coordinate:	38.68566				
Barrier Area:	Sidewalks				
Barrier Type:	Cross Slope - Existing (4.1% to 4.9%)				
Code Ref:	CBC 1133B.7.1.3 and ADA/ABA 403.3

As Built Meas:	110	Quantity:	LF	
Description:	Cross slope exceeds 2.0% (4.1% to 4.9%)			
As Built Desc:	4.8% cross slope			
Solution:	Demolish existing and construct new route			
Bar. Severity:	2 Recommended	Cost Estimate:	\$13,750.00	Status:
Implementation Priority:	4	Facility Function:		
Implementation Phase:		Implementation Date:		
Official Responsible:

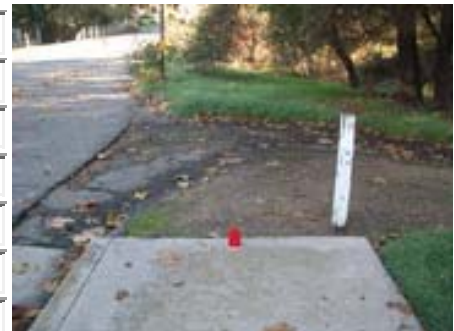
Field Date:	12/7/2010	Report Date:	12/7/2010	Barrier #:	3283
Location:	Woodside Dr - North				
X Coordinate:	-121.29142				
Y Coordinate:	38.68563				
Barrier Area:	Sidewalks				
Barrier Type:	No Sidewalk - Transition to Shoulder				
Code Ref:	CBC 1121B.2 and ADA/ABA 206.2.1

As Built Meas:	1	Quantity:	JOB	
Description:	Sidewalk ends and no ramp to pedestrian shoulder is provided			
As Built Desc:	No ramp to shoulder to enable pedestrian travel onto existing shoulder			
Solution:	Provide transition ramp to paved shoulder where no opposite sidewalk exists			
Bar. Severity:	1 Necessary	Cost Estimate:	\$2,500.00	Status:
Implementation Priority:	4	Facility Function:		
Implementation Phase:		Implementation Date:		
Official Responsible:

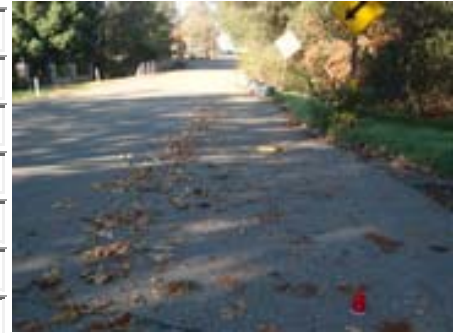
Field Date:	12/7/2010	Report Date:	12/7/2010	Barrier #:	3284
Location:	Woodside Dr - North				
X Coordinate:	-121.29149				
Y Coordinate:	38.6856				
Barrier Area:	Sidewalks				
Barrier Type:	Shoulder Cross Slope - Existing (4.1% to 4.9%)				
Code Ref:	CBC 1133B.7.1.3 and ADA/ABA 403.3

As Built Meas:	220	Quantity:	LF	
Description:	Cross slope exceeds 2.0% (4.1% to 4.9%)			
As Built Desc:	4.3% cross slope			
Solution:	Demolish existing and construct new pedestrian route			
Bar. Severity:	2 Recommended	Cost Estimate:	\$27,500.00	Status:
Implementation Priority:	4	Facility Function:		
Implementation Phase:		Implementation Date:		
Official Responsible:

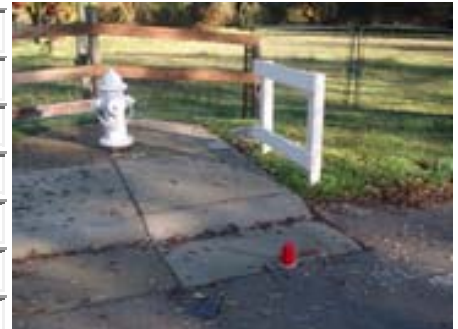
Field Date:	12/7/2010	Report Date:	12/7/2010	Barrier #:	3285
Location:	Woodside Dr - North				
X Coordinate:	-121.2923				
Y Coordinate:	38.68558				
Barrier Area:	Sidewalks				
Barrier Type:	No Sidewalk - Transition to Shoulder				
Code Ref:	CBC 1121B.2 and ADA/ABA 206.2.1

As Built Meas:	1	Quantity:	JOB	
Description:	Sidewalk ends and no ramp to pedestrian shoulder is provided			
As Built Desc:	No ramp to shoulder to enable pedestrian travel onto existing shoulder			
Solution:	Provide transition ramp to paved shoulder where no opposite sidewalk exists			
Bar. Severity:	1 Necessary	Cost Estimate:	\$2,500.00	Status:
Implementation Priority:	4	Facility Function:		
Implementation Phase:		Implementation Date:		
Official Responsible:

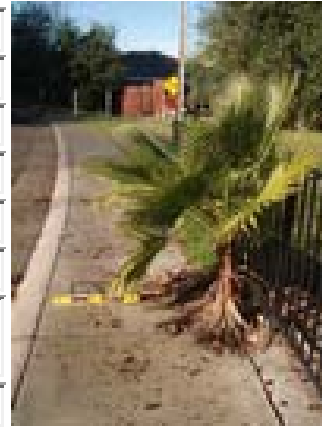
Field Date:	12/7/2010	Report Date:	12/7/2010	Barrier #:	3286
Location:	Woodside Dr - North				
X Coordinate:	-121.2945				
Y Coordinate:	38.68555				
Barrier Area:	Sidewalks				
Barrier Type:	Clear Width - Existing ( $\leq 31"$ or less)				
Code Ref:	CBC 1133B.7.1

As Built Meas:	4	Quantity:	LF	
Description:	Pedestrian route is not min. 48" wide ( $\leq 31"$ or less)			
As Built Desc:	24" clear width due to foliage			
Solution:	Trim foliage			
Bar. Severity:	1 Necessary	Cost Estimate:	\$125.00	Status:
Implementation Priority:	4	Facility Function:		
Implementation Phase:		Implementation Date:		
Official Responsible:

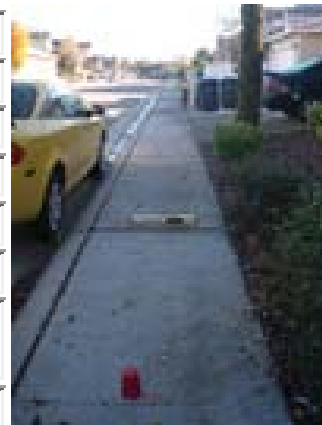
Field Date:	12/7/2010	Report Date:	12/7/2010	Barrier #:	3287
Location:	Thalia Wy - South				
X Coordinate:	-121.29547				
Y Coordinate:	38.68657				
Barrier Area:	Sidewalks				
Barrier Type:	Cross Slope - Existing (2.1% to 3.0%)				
Code Ref:	CBC 1133B.7.1.3 and ADA/ABA 403.3

As Built Meas:	105	Quantity:	LF	
Description:	Cross slope exceeds 2.0% (2.1% to 3.0%)			
As Built Desc:	3.0% cross slope			
Solution:	Low severity barrier - no remediation recommended			
Bar. Severity:	4 Low Severity	Cost Estimate:	\$0.00	Status:
Implementation Priority:	4	Facility Function:		
Implementation Phase:		Implementation Date:		
Official Responsible:

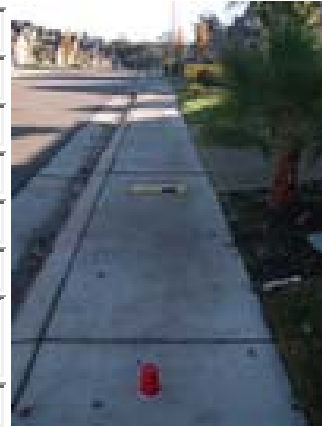
Field Date:	12/7/2010	Report Date:	12/7/2010	Barrier #:	3288
Location:	Thalia Wy - South				
X Coordinate:	-121.29492				
Y Coordinate:	38.68655				
Barrier Area:	Sidewalks				
Barrier Type:	Cross Slope - Existing (3.1% to 4.0%)				
Code Ref:	CBC 1133B.7.1.3 and ADA/ABA 403.3

As Built Meas:	144	Quantity:	LF	
Description:	Cross slope exceeds 2.0% (3.1% to 4.0%)			
As Built Desc:	3.2% cross slope			
Solution:	Demolish existing and construct new route			
Bar. Severity:	3 Hinderance	Cost Estimate:	\$18,000.00	Status:
Implementation Priority:	4	Facility Function:		
Implementation Phase:		Implementation Date:		
Official Responsible:

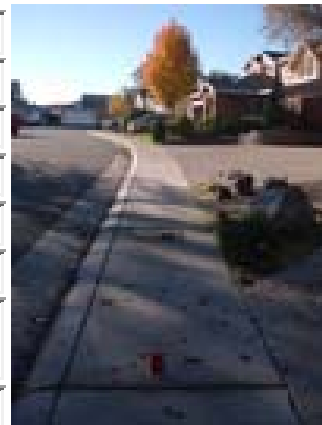
Field Date:	12/7/2010	Report Date:	12/7/2010	Barrier #:	3289
Location:	Hespera Wy - West				
X Coordinate:	-121.29513				
Y Coordinate:	38.68719				
Barrier Area:	Sidewalks				
Barrier Type:	Cross Slope - Existing (3.1% to 4.0%)				
Code Ref:	CBC 1133B.7.1.3 and ADA/ABA 403.3

As Built Meas:	190	Quantity:	LF	
Description:	Cross slope exceeds 2.0% (3.1% to 4.0%)			
As Built Desc:	3.6% cross slope			
Solution:	Demolish existing and construct new route			
Bar. Severity:	3 Hinderance	Cost Estimate:	\$23,750.00	Status:
Implementation Priority:	4	Facility Function:		
Implementation Phase:		Implementation Date:		
Official Responsible:

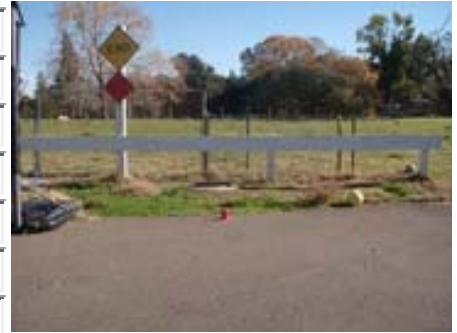
Field Date:	12/7/2010	Report Date:	12/7/2010	Barrier #:	3290
Location:	Hera Ct - South				
X Coordinate:	-121.29394				
Y Coordinate:	38.68443				
Barrier Area:	Sidewalks				
Barrier Type:	No Sidewalk - Cane Detectable Barricade				
Code Ref:	CBC 1133B.8.6 and MUTCD Section 6D.02

As Built Meas:	40	Quantity:	LF		
Description:	No cane detectable warning on existing barricade				
As Built Desc:	Existing barricade lacks warning for the visually impaired				
Solution:	Provide cane detectable warning on barricade (max. 6" above ground)				
Bar. Severity:	1 Necessary	Cost Estimate:	\$4,000.00	Status:	
Implementation Priority:	4	Facility Function:			
Implementation Phase:		Implementation Date:			
Official Responsible:

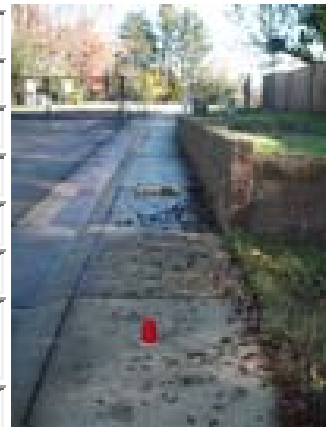
Field Date:	12/7/2010	Report Date:	12/7/2010	Barrier #:	3291A
Location:	Woodside Dr - South				
X Coordinate:	-121.29426				
Y Coordinate:	38.68546				
Barrier Area:	Sidewalks				
Barrier Type:	Cross Slope - Existing (3.1% to 4.0%)				
Code Ref:	CBC 1133B.7.1.3 and ADA/ABA 403.3

As Built Meas:	163	Quantity:	LF		
Description:	Cross slope exceeds 2.0% (3.1% to 4.0%)				
As Built Desc:	3.5% cross slope				
Solution:	Demolish existing and construct new route				
Bar. Severity:	3 Hinderance	Cost Estimate:	\$20,375.00	Status:	
Implementation Priority:	4	Facility Function:			
Implementation Phase:		Implementation Date:			
Official Responsible:

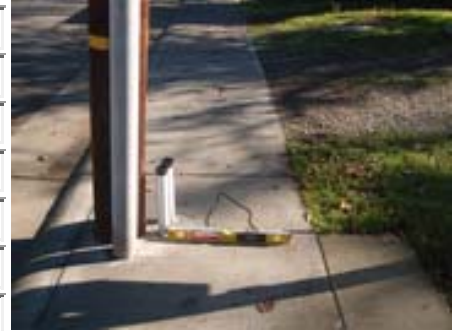
Field Date:	12/7/2010	Report Date:	12/7/2010	Barrier #:	3291B
Location:	Woodside Dr - South				
X Coordinate:	-121.2939				
Y Coordinate:	38.68546				
Barrier Area:	Sidewalks				
Barrier Type:	Clear Width - Existing ( $\leq 31"$ or less)				
Code Ref:	CBC 1133B.7.1

As Built Meas:	4	Quantity:	LF		
Description:	Pedestrian route is not min. 48" wide ( $\leq 31"$ or less)				
As Built Desc:	28" clear width due to pole				
Solution:	Demolish existing and construct new route				
Bar. Severity:	1 Necessary	Cost Estimate:	\$500.00	Status:	
Implementation Priority:	4	Facility Function:			
Implementation Phase:		Implementation Date:			
Official Responsible:

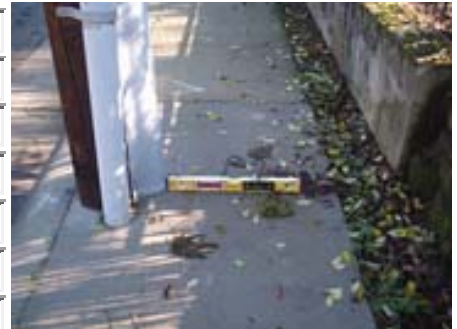
Field Date:	12/7/2010	Report Date:	12/7/2010	Barrier #:	3292
Location:	Woodside Dr - South				
X Coordinate:	-121.29338				
Y Coordinate:	38.68546				
Barrier Area:	Sidewalks				
Barrier Type:	Clear Width - Existing ( $\leq 31"$ or less)				
Code Ref:	CBC 1133B.7.1

As Built Meas:	4	Quantity:	LF		
Description:	Pedestrian route is not min. 48" wide ( $\leq 31"$ or less)				
As Built Desc:	28" clear width due to pole				
Solution:	Demolish existing and construct new route				
Bar. Severity:	1 Necessary	Cost Estimate:	\$500.00	Status:	
Implementation Priority:	44	Facility Function:			
Implementation Phase:		Implementation Date:			
Official Responsible:

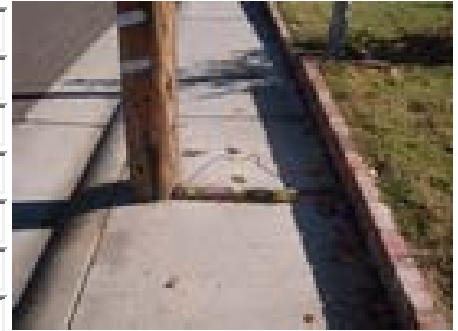
Field Date:	12/7/2010	Report Date:	12/7/2010	Barrier #:	3293
Location:	Woodside Dr - South				
X Coordinate:	-121.29277				
Y Coordinate:	38.68549				
Barrier Area:	Sidewalks				
Barrier Type:	Clear Width - Existing ( $\leq 31"$ or less)				
Code Ref:	CBC 1133B.7.1

As Built Meas:	4	Quantity:	LF	
Description:	Pedestrian route is not min. 48" wide ( $\leq 31"$ or less)			
As Built Desc:	30" clear width due to pole			
Solution:	Demolish existing and construct new route			
Bar. Severity:	1 Necessary	Cost Estimate:	\$500.00	Status:
Implementation Priority:	4	Facility Function:		
Implementation Phase:		Implementation Date:		
Official Responsible:

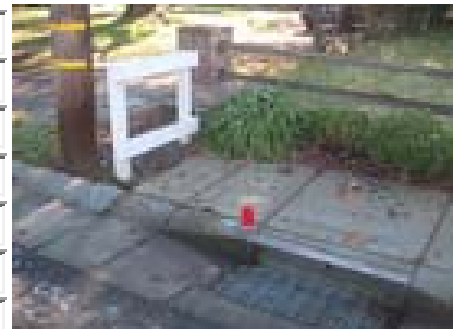
Field Date:	12/7/2010	Report Date:	12/7/2010	Barrier #:	3294
Location:	Woodside Dr - South				
X Coordinate:	-121.29246				
Y Coordinate:	38.68551				
Barrier Area:	Sidewalks				
Barrier Type:	No Sidewalk - Transition to Shoulder				
Code Ref:	CBC 1121B.2 and ADA/ABA 206.2.1

As Built Meas:	1	Quantity:	JOB	
Description:	Sidewalk ends and no ramp to pedestrian shoulder is provided			
As Built Desc:	No ramp to shoulder to enable pedestrian travel onto existing shoulder			
Solution:	Provide transition ramp to paved shoulder where no opposite sidewalk exists			
Bar. Severity:	1 Necessary	Cost Estimate:	\$2,500.00	Status:
Implementation Priority:	4	Facility Function:		
Implementation Phase:		Implementation Date:		
Official Responsible:

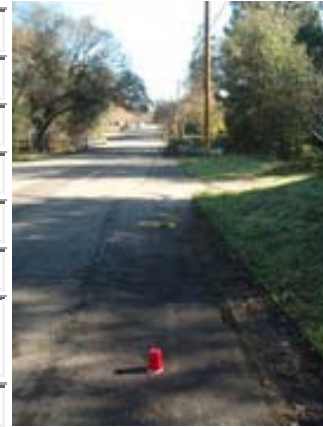
Field Date:	12/7/2010	Report Date:	12/7/2010	Barrier #:	3295
Location:	Woodside Dr - South				
X Coordinate:	-121.29173				
Y Coordinate:	38.68548				
Barrier Area:	Sidewalks				
Barrier Type:	Shoulder Cross Slope - Existing (5.0% or more)				
Code Ref:	CBC 1133B.7.1.3 and ADA/ABA 403.3

As Built Meas:	126	Quantity:	LF	
Description:	Cross slope exceeds 2.0% (5.0% or more)			
As Built Desc:	5.6% cross slope			
Solution:	Demolish existing and construct new pedestrian route			
Bar. Severity:	1 Necessary	Cost Estimate:	\$15,750.00	Status:
Implementation Priority:	4	Facility Function:		
Implementation Phase:		Implementation Date:		
Official Responsible:

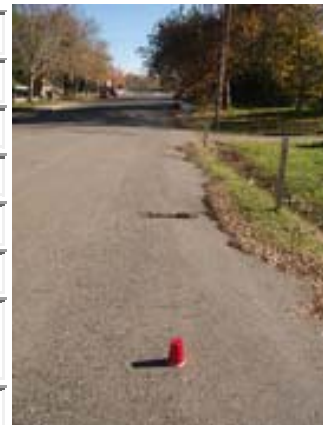
Field Date:	12/7/2010	Report Date:	12/7/2010	Barrier #:	3296
Location:	Woodside Dr - South				
X Coordinate:	-121.29096				
Y Coordinate:	38.68541				
Barrier Area:	Sidewalks				
Barrier Type:	Shoulder Cross Slope - Existing (4.1% to 4.9%)				
Code Ref:	CBC 1133B.7.1.3 and ADA/ABA 403.3

As Built Meas:	216	Quantity:	LF	
Description:	Cross slope exceeds 2.0% (4.1% to 4.9%)			
As Built Desc:	4.1% cross slope			
Solution:	Demolish existing and construct new pedestrian route			
Bar. Severity:	2 Recommended	Cost Estimate:	\$27,000.00	Status:
Implementation Priority:	4	Facility Function:		
Implementation Phase:		Implementation Date:		
Official Responsible:

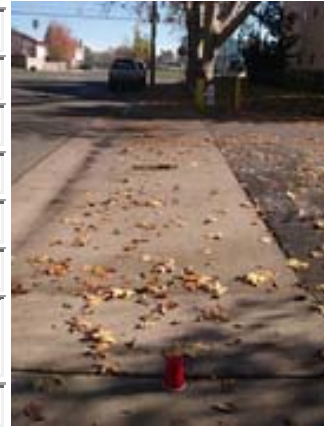
Field Date:	12/7/2010	Report Date:	12/7/2010	Barrier #:	3297
Location:	Woodside Dr - South				
X Coordinate:	-121.29049				
Y Coordinate:	38.68532				
Barrier Area:	Sidewalks				
Barrier Type:	Driveway - Existing (4.1% to 4.9%)				
Code Ref:	CBC 1133B.7.1.3 and ADA/ABA 403.3

As Built Meas:	38	Quantity:	LF	
Description:	Driveway cross slope exceeds 2.0% (4.1% to 4.9%)			
As Built Desc:	4.2% cross slope, 10.4% running slope			
Solution:	Provide min. 48" wide level walkway through driveway			
Bar. Severity:	1 Necessary	Cost Estimate:	\$4,750.00	Status:
Implementation Priority:	4	Facility Function:		
Implementation Phase:		Implementation Date:		
Official Responsible:

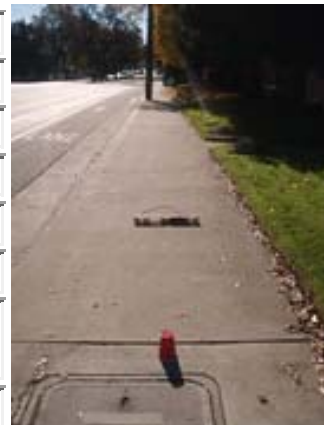
Field Date:	12/7/2010	Report Date:	12/7/2010	Barrier #:	3298
Location:	Sylvan Rd - West				
X Coordinate:	-121.29044				
Y Coordinate:	38.68479				
Barrier Area:	Sidewalks				
Barrier Type:	Cross Slope - Existing (3.1% to 4.0%)				
Code Ref:	CBC 1133B.7.1.3 and ADA/ABA 403.3

As Built Meas:	156	Quantity:	LF	
Description:	Cross slope exceeds 2.0% (3.1% to 4.0%)			
As Built Desc:	3.8% cross slope			
Solution:	Demolish existing and construct new route			
Bar. Severity:	3 Hinderance	Cost Estimate:	\$19,500.00	Status:
Implementation Priority:	4	Facility Function:		
Implementation Phase:		Implementation Date:		
Official Responsible:

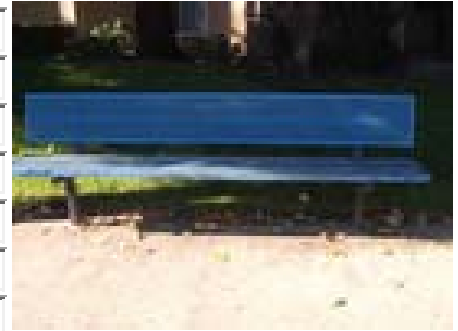
Field Date:	12/7/2010	Report Date:	12/7/2010	Barrier #:	3299A
Location:	Sylvan Rd - West				
X Coordinate:	-121.29045				
Y Coordinate:	38.68466				
Barrier Area:	Bus Stops and Shelters				
Barrier Type:	Bench Seat Depth				
Code Ref:	ADAAG 4.37.1 and ADA/ABA 903.4

As Built Meas:	1	Quantity:	EACH	
Description:	Bench seat depth not 20" - 24" deep			
As Built Desc:	12-1/2" bench seat depth			
Solution:	Provide min. 1 accessible bench at bench stop			
Bar. Severity:	3 Hindrance	Cost Estimate:	\$775.00	Status:
Implementation Priority:	4	Facility Function:		
Implementation Phase:		Implementation Date:		
Official Responsible:
