**DRAFT ADA TRANSITION PLAN UPDATE  
NEIGHBORHOOD AREA 4 ARCADE CREEK  
SEPTEMBER 20, 2011**

CITY OF CITRUS HEIGHTS

## Arcade Creek Neighborhood Area

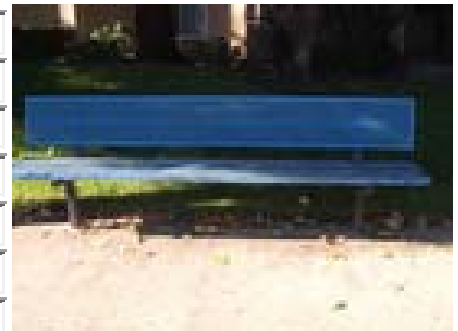
Field Date:	12/7/2010	Report Date:	12/7/2010	Barrier #:	3299B
Location:	Sylvan Rd - West				
X Coordinate:	-121.29045				
Y Coordinate:	38.68466				
Barrier Area:	Bus Stops and Shelters				
Barrier Type:	Bench Back Support				
Code Ref:	ADAAG 4.37.4 and ADA/ABA 903.4

As Built Meas:	1	Quantity:	EACH	
Description:	Bench has no back support of at least 18" high			
As Built Desc:	16-1/2" back support height			
Solution:	Provide min. 1 accessible bench at bench stop or shelter			
Bar. Severity:	3 Hindrance	Cost Estimate:	\$0.00	Status:
Implementation Priority:	4	Facility Function:		
Implementation Phase:		Implementation Date:		
Official Responsible:

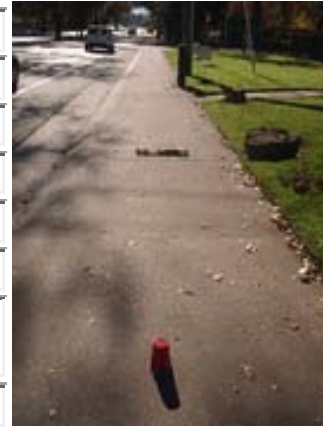
Field Date:	12/7/2010	Report Date:	12/7/2010	Barrier #:	3300
Location:	Sylvan Rd - West				
X Coordinate:	-121.29044				
Y Coordinate:	38.68427				
Barrier Area:	Sidewalks				
Barrier Type:	Cross Slope - Existing (3.1% to 4.0%)				
Code Ref:	CBC 1133B.7.1.3 and ADA/ABA 403.3

As Built Meas:	121	Quantity:	LF	
Description:	Cross slope exceeds 2.0% (3.1% to 4.0%)			
As Built Desc:	3.8% cross slope			
Solution:	Demolish existing and construct new route			
Bar. Severity:	3 Hinderance	Cost Estimate:	\$15,125.00	Status:
Implementation Priority:	4	Facility Function:		
Implementation Phase:		Implementation Date:		
Official Responsible:

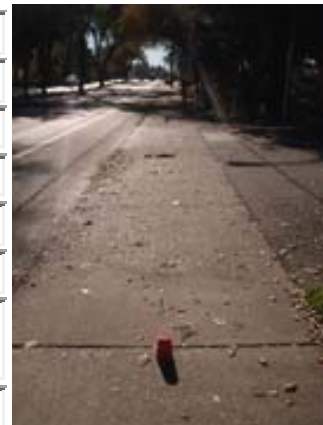
Field Date:	12/7/2010	Report Date:	12/7/2010	Barrier #:	3301
Location:	Sylvan Rd - West				
X Coordinate:	-121.29046				
Y Coordinate:	38.68419				
Barrier Area:	Sidewalks				
Barrier Type:	Driveway - Existing (5.0% or more)				
Code Ref:	CBC 1133B.7.1.3 and ADA/ABA 403.3

As Built Meas:	134	Quantity:	LF	
Description:	Driveway cross slope exceeds 2.0% (5.0% or more)			
As Built Desc:	5.0% cross slope			
Solution:	Provide min. 48" wide level walkway through driveway			
Bar. Severity:	4 Low Severity	Cost Estimate:	\$16,750.00	Status:
Implementation Priority:	4	Facility Function:		
Implementation Phase:		Implementation Date:		
Official Responsible:

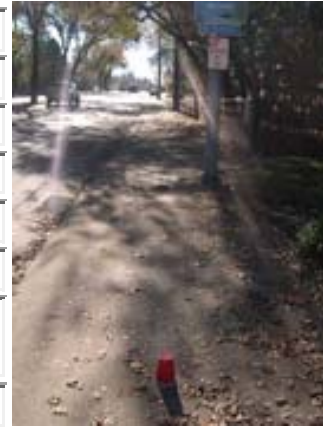
Field Date:	12/7/2010	Report Date:	12/7/2010	Barrier #:	3302
Location:	Stock Ranch Rd - North				
X Coordinate:	-121.29081				
Y Coordinate:	38.68202				
Barrier Area:	Sidewalks				
Barrier Type:	Driveway - Existing (3.1% to 4.0%)				
Code Ref:	CBC 1133B.7.1.3 and ADA/ABA 403.3

As Built Meas:	52	Quantity:	LF	
Description:	Driveway cross slope exceeds 2.0% (3.1% to 4.0%)			
As Built Desc:	3.8% cross slope			
Solution:	Provide min. 48" wide level walkway through driveway			
Bar. Severity:	2 Recommended	Cost Estimate:	\$6,500.00	Status:
Implementation Priority:	4	Facility Function:		
Implementation Phase:		Implementation Date:		
Official Responsible:

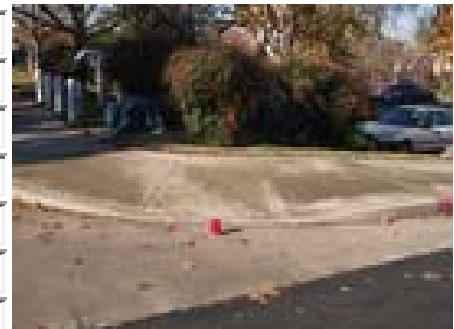
Field Date:	12/7/2010	Report Date:	12/7/2010	Barrier #:	3303A
Location:	Stock Ranch Rd and Emeritus Entrance - Corner A				
X Coordinate:	-121.29322				
Y Coordinate:	38.68197				
Barrier Area:	Curb Ramps				
Barrier Type:	12" Grooves - Existing (3.1% to 4.0%)				
Code Ref:	CBC 1127B.5.6

As Built Meas:	1	Quantity:	EACH	
Description:	12" grooves at top of curb ramp are not level (3.1% to 4.0%)			
As Built Desc:	3.8% at 12" grooves			
Solution:	Demolish existing and construct new curb ramp			
Bar. Severity:	3 Hindrance	Cost Estimate:	\$2,500.00	Status:
Implementation Priority:	4	Facility Function:		
Implementation Phase:		Implementation Date:		
Official Responsible:

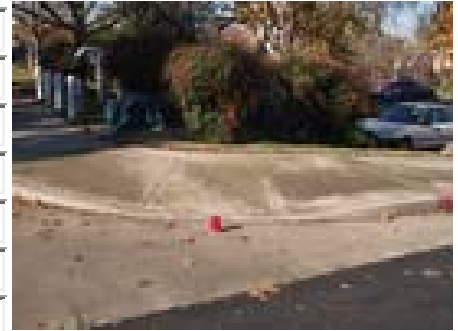
Field Date:	12/7/2010	Report Date:	12/7/2010	Barrier #:	3303B
Location:	Stock Ranch Rd and Emeritus Entrance - Corner A				
X Coordinate:	-121.29322				
Y Coordinate:	38.68197				
Barrier Area:	Curb Ramps				
Barrier Type:	Running Slope - Existing (8.6% to 8.9%)				
Code Ref:	CBC 1127B.5.3 and ADA/ABA 406.1

As Built Meas:	1	Quantity:	EACH		
Description:	Ramp run cross slope exceeds 2.0% (8.6% to 8.9%)				
As Built Desc:	8.9% running slope				
Solution:	Demolish existing and construct new curb ramp				
Bar. Severity:	3 Hindrance	Cost Estimate:	\$0.00	Status:	
Implementation Priority:	4	Facility Function:			
Implementation Phase:		Implementation Date:			
Official Responsible:

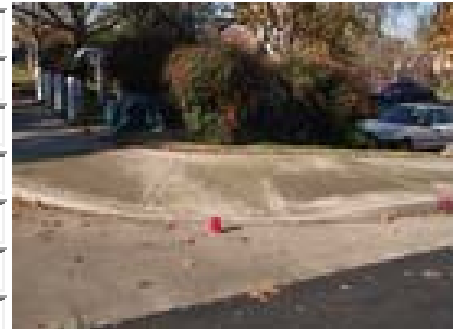
Field Date:	12/7/2010	Report Date:	12/7/2010	Barrier #:	3303C
Location:	Stock Ranch Rd and Emeritus Entrance - Corner A				
X Coordinate:	-121.29322				
Y Coordinate:	38.68197				
Barrier Area:	Curb Ramps				
Barrier Type:	Detectable Warnings - Truncated Domes				
Code Ref:	CBC 1127B.5.7 and ADA/ABA 705.1.3

As Built Meas:	1	Quantity:	EACH		
Description:	No truncated domes provided at curb ramp				
As Built Desc:	No detectable warnings at curb ramp				
Solution:	Provide compliant truncated domes				
Bar. Severity:	2 Recommended	Cost Estimate:	\$0.00	Status:	
Implementation Priority:	4	Facility Function:			
Implementation Phase:		Implementation Date:			
Official Responsible:

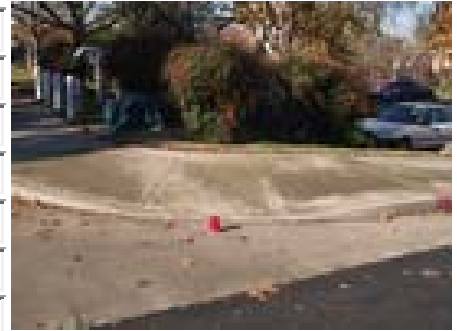
Field Date:	12/7/2010	Report Date:	12/7/2010	Barrier #:	3303D
Location:	Stock Ranch Rd and Emeritus Entrance - Corner A				
X Coordinate:	-121.29322				
Y Coordinate:	38.68197				
Barrier Area:	Curb Ramps				
Barrier Type:	Lip - Bottom of Ramp at Flow Line				
Code Ref:	CBC 1127B.5.3 and ADA/ABA 303.3

As Built Meas:	1	Quantity:	EACH	
Description:	Transition at ramp bottom (flow line) is not flush and free of any lip			
As Built Desc:	1" lip at flow line			
Solution:	Remove lip to create flush transition			
Bar. Severity:	1 Necessary	Cost Estimate:	\$0.00	Status:
Implementation Priority:	4	Facility Function:		
Implementation Phase:		Implementation Date:		
Official Responsible:

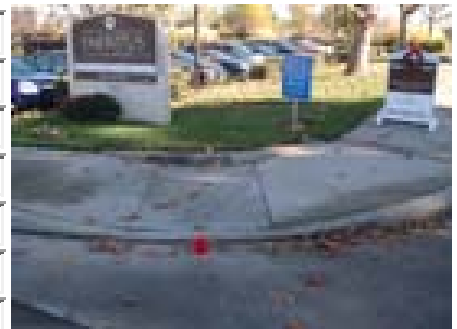
Field Date:	12/7/2010	Report Date:	12/7/2010	Barrier #:	3304A
Location:	Stock Ranch Rd and Emeritus Entrance - Corner B				
X Coordinate:	-121.29303				
Y Coordinate:	38.68193				
Barrier Area:	Curb Ramps				
Barrier Type:	12" Grooves - Existing (4.1% to 4.9%)				
Code Ref:	CBC 1127B.5.6

As Built Meas:	1	Quantity:	EACH	
Description:	12" grooves at top of curb ramp are not level (4.1% to 4.9%)			
As Built Desc:	4.5% at 12" grooves			
Solution:	Demolish existing and construct new curb ramp			
Bar. Severity:	2 Recommended	Cost Estimate:	\$2,500.00	Status:
Implementation Priority:	4	Facility Function:		
Implementation Phase:		Implementation Date:		
Official Responsible:

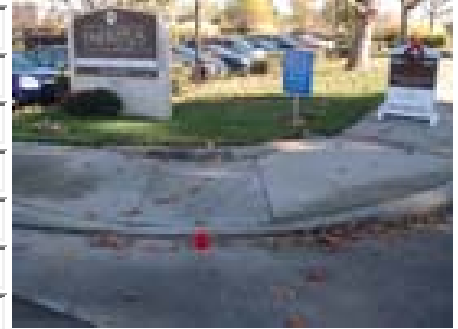
Field Date:	12/7/2010	Report Date:	12/7/2010	Barrier #:	3304B
Location:	Stock Ranch Rd and Emeritus Entrance - Corner B				
X Coordinate:	-121.29303				
Y Coordinate:	38.68193				
Barrier Area:	Curb Ramps				
Barrier Type:	Running Slope - Existing (9.5% or more)				
Code Ref:	CBC 1127B.5.3 and ADA/ABA 406.1

As Built Meas:	1	Quantity:	EACH
Description:	Ramp run cross slope exceeds 2.0% (9.5% or more)		
As Built Desc:	12.0% running slope		
Solution:	Demolish existing and construct new curb ramp		
Bar. Severity:	1 Necessary	Cost Estimate:	\$0.00
Implementation Priority:	4	Facility Function:	
Implementation Phase:		Implementation Date:	
Official Responsible:

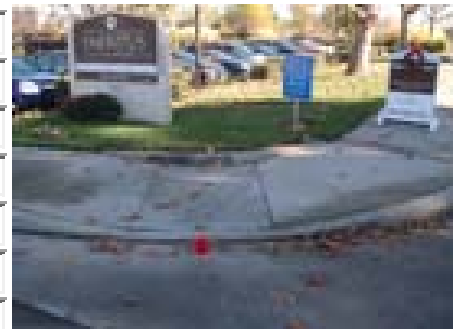
Field Date:	12/7/2010	Report Date:	12/7/2010	Barrier #:	3304C
Location:	Stock Ranch Rd and Emeritus Entrance - Corner B				
X Coordinate:	-121.29303				
Y Coordinate:	38.68193				
Barrier Area:	Curb Ramps				
Barrier Type:	Parallel Ramp Landing - Existing (4.1% to 4.9%)				
Code Ref:	CBC 1127B.5.4 and ADA/ABA 406.4

As Built Meas:	1	Quantity:	EACH
Description:	Curb ramp landing or pan not level(4.1% to 4.9%)		
As Built Desc:	4.8% landing slope		
Solution:	Demolish existing and construct new transition		
Bar. Severity:	2 Recommended	Cost Estimate:	\$0.00
Implementation Priority:	4	Facility Function:	
Implementation Phase:		Implementation Date:	
Official Responsible:

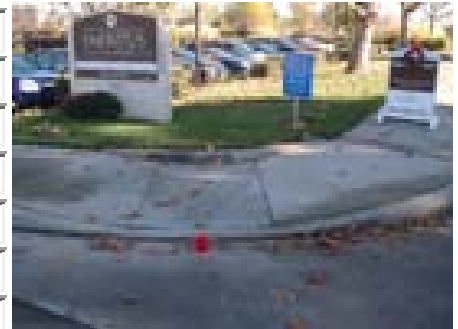
Field Date:	12/7/2010	Report Date:	12/7/2010	Barrier #:	3304E
Location:	Stock Ranch Rd and Emeritus Entrance - Corner B				
X Coordinate:	-121.29303				
Y Coordinate:	38.68193				
Barrier Area:	Curb Ramps				
Barrier Type:	Lip - Bottom of Ramp at Flow Line				
Code Ref:	CBC 1127B.5.3 and ADA/ABA 303.3

As Built Meas:	1	Quantity:	EACH	
Description:	Transition at ramp bottom (flow line) is not flush and free of any lip			
As Built Desc:	1/2" lip at flow line			
Solution:	Remove lip to create flush transition			
Bar. Severity:	1 Necessary	Cost Estimate:	\$0.00	Status:
Implementation Priority:	4	Facility Function:		
Implementation Phase:		Implementation Date:		
Official Responsible:

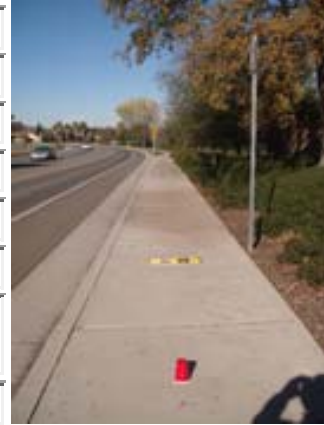
Field Date:	12/7/2010	Report Date:	12/7/2010	Barrier #:	3305
Location:	Stock Ranch Rd - North				
X Coordinate:	-121.29499				
Y Coordinate:	38.68279				
Barrier Area:	Sidewalks				
Barrier Type:	Cross Slope - Existing (2.1% to 3.0%)				
Code Ref:	CBC 1133B.7.1.3 and ADA/ABA 403.3

As Built Meas:	312	Quantity:	LF		
Description:	Cross slope exceeds 2.0% (2.1% to 3.0%)				
As Built Desc:	2.4% cross slope				
Solution:	Low severity barrier - no remediation recommended				
Bar. Severity:	4 Low Severity	Cost Estimate:	\$0.00	Status:	
Implementation Priority:	4	Facility Function:			
Implementation Phase:		Implementation Date:			
Official Responsible:

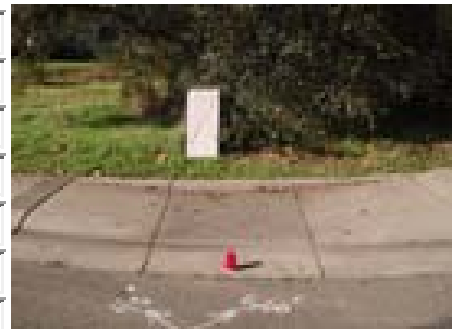
Field Date:	12/7/2010	Report Date:	12/7/2010	Barrier #:	3306
Location:	Stock Ranch Rd and Aspen Gardens Wy - Corner A				
X Coordinate:	-121.29779				
Y Coordinate:	38.68637				
Barrier Area:	Curb Ramps				
Barrier Type:	Detectable Warnings - Truncated Domes				
Code Ref:	CBC 1127B.5.7 and ADA/ABA 705.1.3

As Built Meas:	1	Quantity:	EACH		
Description:	No truncated domes provided at curb ramp				
As Built Desc:	No detectable warnings at curb ramp				
Solution:	Provide compliant truncated domes				
Bar. Severity:	2 Recommended	Cost Estimate:	\$1,400.00	Status:	
Implementation Priority:	4	Facility Function:			
Implementation Phase:		Implementation Date:			
Official Responsible:

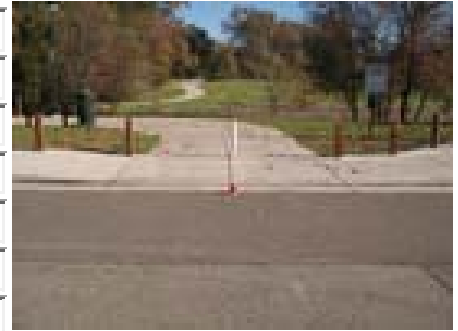
Field Date:	12/7/2010	Report Date:	12/7/2010	Barrier #:	3307A
Location:	Stock Ranch Rd and Aspen Gardens Wy - Corner C				
X Coordinate:	-121.29752				
Y Coordinate:	38.68632				
Barrier Area:	Curb Ramps				
Barrier Type:	12" Grooves - New Construction				
Code Ref:	CBC 1127B.5.6

As Built Meas:	1	Quantity:	EACH	
Description:	No 12" grooves at top of curb ramp			
As Built Desc:	No 12" grooves provided at top of ramp			
Solution:	Demolish existing and construct new curb ramp			
Bar. Severity:	1 Necessary	Cost Estimate:	\$2,500.00	Status:
Implementation Priority:	4	Facility Function:		
Implementation Phase:		Implementation Date:		
Official Responsible:

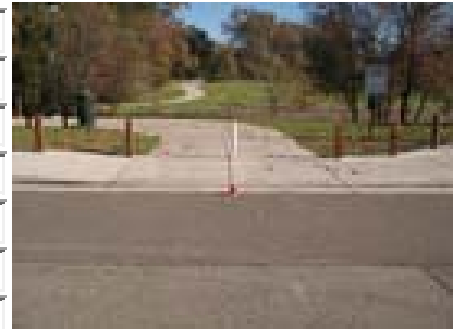
As Built Meas:	1	Quantity:	EACH	
Description:	No truncated domes provided at curb ramp			
As Built Desc:	No detectable warnings at curb ramp			
Solution:	Provide compliant truncated domes			
Bar. Severity:	2 Recommended	Cost Estimate:	\$0.00	Status:
Implementation Priority:	4	Facility Function:		
Implementation Phase:		Implementation Date:		
Official Responsible:

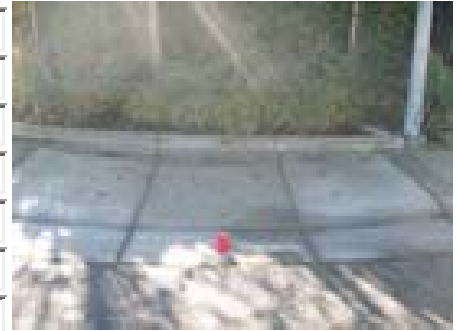
Barrier Type: Detectable Warnings - Truncated Domes

Description: No truncated domes provided at curb ramp

Bar. Severity: 2 Recommended Cost Estimate: \$1,400.00 Status:

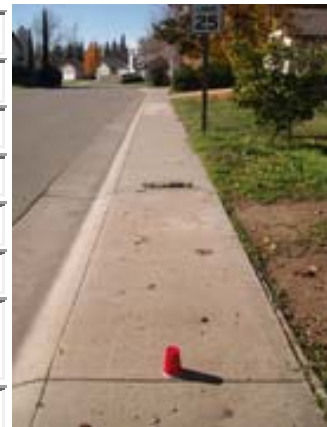
Barrier Type: Cross Slope - Existing (3.1% to 4.0%)

Description: Cross slope exceeds 2.0% (3.1% to 4.0%)

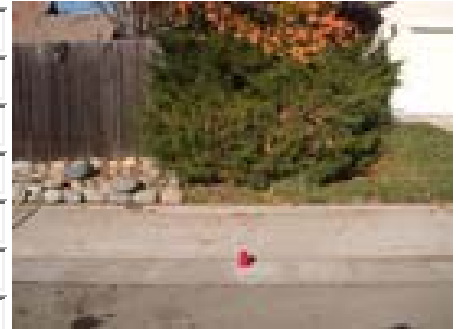
As Built Meas:	1	Quantity:	EACH
Description:	No truncated domes provided at curb ramp		
As Built Desc:	No detectable warnings at curb ramp		
Solution:	Provide compliant truncated domes		
Bar. Severity:	2 Recommended	Cost Estimate:	\$1,400.00
Implementation Priority:	4	Facility Function:	
Implementation Phase:		Implementation Date:	
Official Responsible:

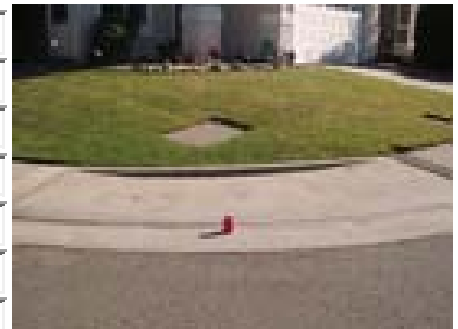
Field Date:	12/7/2010	Report Date:	12/7/2010	Barrier #:	3311A
Location:	Aspen Gardens Wy and Ryan Taylor Wy - Corner C				
X Coordinate:	-121.29808				
Y Coordinate:	38.68614				
Barrier Area:	Curb Ramps				
Barrier Type:	12" Grooves - Existing (3.1% to 4.0%)				
Code Ref:	CBC 1127B.5.6

As Built Meas:	1	Quantity:	EACH
Description:	12" grooves at top of curb ramp are not level (3.1% to 4.0%)		
As Built Desc:	3.2% at 12" grooves		
Solution:	Demolish existing and construct new curb ramp		
Bar. Severity:	3 Hindrance	Cost Estimate:	\$2,500.00
Implementation Priority:	4	Facility Function:	
Implementation Phase:		Implementation Date:	
Official Responsible:

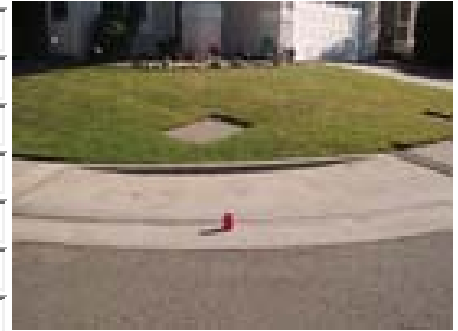
As Built Meas:	1	Quantity:	EACH	
Description:	No truncated domes provided at curb ramp			
As Built Desc:	No detectable warnings at curb ramp			
Solution:	Provide compliant truncated domes			
Bar. Severity:	2 Recommended	Cost Estimate:	\$0.00	Status:
Implementation Priority:	4	Facility Function:		
Implementation Phase:		Implementation Date:		
Official Responsible:

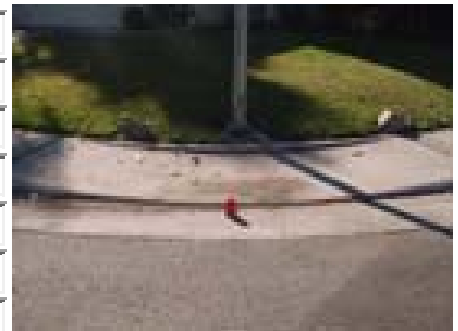
As Built Meas:	1	Quantity:	EACH	
Description:	No truncated domes provided at curb ramp			
As Built Desc:	No detectable warnings at curb ramp			
Solution:	Provide compliant truncated domes			
Bar. Severity:	2 Recommended	Cost Estimate:	\$1,400.00	Status:
Implementation Priority:	4	Facility Function:		
Implementation Phase:		Implementation Date:		
Official Responsible:

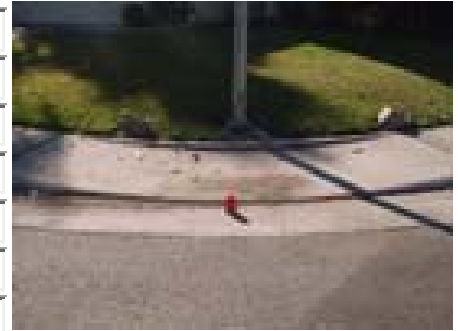
As Built Meas:	1	Quantity:	EACH		
Description:	Transition at transition into asphalt not flush and free of any lip				
As Built Desc:	1/2" lip at asphalt transition into roadway				
Solution:	Remove lip to create flush transition				
Bar. Severity:	1 Necessary	Cost Estimate:	\$250.00	Status:	
Implementation Priority:	4	Facility Function:			
Implementation Phase:		Implementation Date:			
Official Responsible:

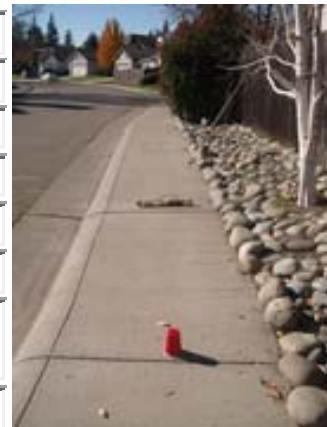
Field Date:	12/7/2010	Report Date:	12/7/2010	Barrier #:	3313A
Location:	Aspen Gardens Wy - North				
X Coordinate:	-121.29826				
Y Coordinate:	38.68623				
Barrier Area:	Sidewalks				
Barrier Type:	Cross Slope - Existing (3.1% to 4.0%)				
Code Ref:	CBC 1133B.7.1.3 and ADA/ABA 403.3

As Built Meas:	62	Quantity:	LF		
Description:	Cross slope exceeds 2.0% (3.1% to 4.0%)				
As Built Desc:	3.8% cross slope				
Solution:	Demolish existing and construct new route				
Bar. Severity:	3 Hinderance	Cost Estimate:	\$7,750.00	Status:	
Implementation Priority:	4	Facility Function:			
Implementation Phase:		Implementation Date:			
Official Responsible:

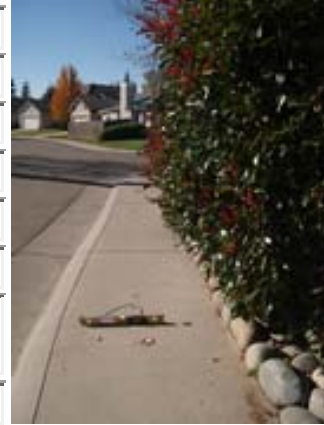
Field Date:	12/7/2010	Report Date:	12/7/2010	Barrier #:	3313B
Location:	Aspen Gardens Wy - North				
X Coordinate:	-121.29839				
Y Coordinate:	38.68619				
Barrier Area:	Sidewalks				
Barrier Type:	Clear Width - Existing ( $\leq 31"$ or less)				
Code Ref:	CBC 1133B.7.1

As Built Meas:	2	Quantity:	LF	
Description:	Pedestrian route is not min. 48" wide ( $\leq 31"$ or less)			
As Built Desc:	30" clear width due to foliage			
Solution:	Trim foliage			
Bar. Severity:	1 Necessary	Cost Estimate:	\$125.00	Status:
Implementation Priority:	4	Facility Function:		
Implementation Phase:		Implementation Date:		
Official Responsible:

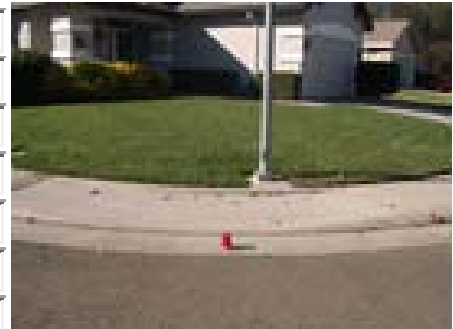
As Built Meas:	1	Quantity:	EACH	
Description:	No truncated domes provided at curb ramp			
As Built Desc:	No detectable warnings at curb ramp			
Solution:	Provide compliant truncated domes			
Bar. Severity:	2 Recommended	Cost Estimate:	\$1,400.00	Status:
Implementation Priority:	4	Facility Function:		
Implementation Phase:		Implementation Date:		
Official Responsible:

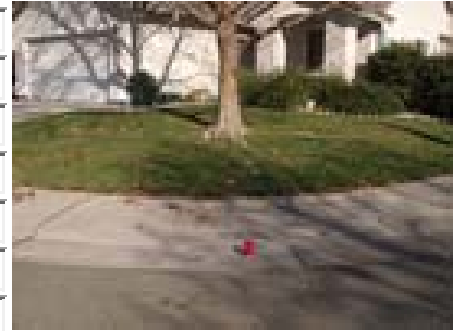
As Built Meas:	1	Quantity:	EACH		
Description:	No truncated domes provided at curb ramp				
As Built Desc:	No detectable warnings at curb ramp				
Solution:	Provide compliant truncated domes				
Bar. Severity:	2 Recommended	Cost Estimate:	\$1,400.00	Status:	
Implementation Priority:	4	Facility Function:			
Implementation Phase:		Implementation Date:			
Official Responsible:

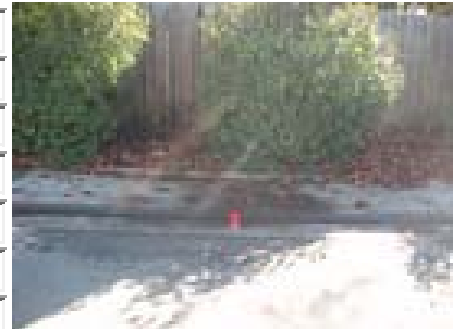
As Built Meas:	1	Quantity:	EACH		
Description:	No truncated domes provided at curb ramp				
As Built Desc:	No detectable warnings at curb ramp				
Solution:	Provide compliant truncated domes				
Bar. Severity:	2 Recommended	Cost Estimate:	\$1,400.00	Status:	
Implementation Priority:	4	Facility Function:			
Implementation Phase:		Implementation Date:			
Official Responsible:

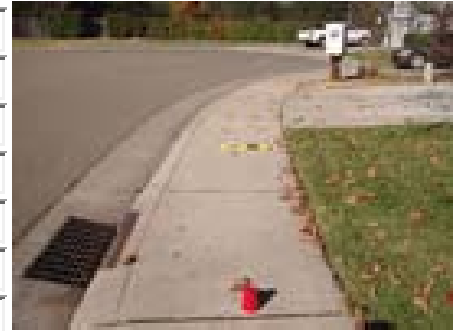
Field Date:	12/7/2010	Report Date:	12/7/2010	Barrier #:	3317
Location:	Aspen Glen Ct - North				
X Coordinate:	-121.29868				
Y Coordinate:	38.68626				
Barrier Area:	Sidewalks				
Barrier Type:	Cross Slope - Existing (3.1% to 4.0%)				
Code Ref:	CBC 1133B.7.1.3 and ADA/ABA 403.3

As Built Meas:	136	Quantity:	LF		
Description:	Cross slope exceeds 2.0% (3.1% to 4.0%)				
As Built Desc:	3.6% cross slope				
Solution:	Demolish existing and construct new route				
Bar. Severity:	3 Hinderance	Cost Estimate:	\$17,000.00	Status:	
Implementation Priority:	4	Facility Function:			
Implementation Phase:		Implementation Date:			
Official Responsible:

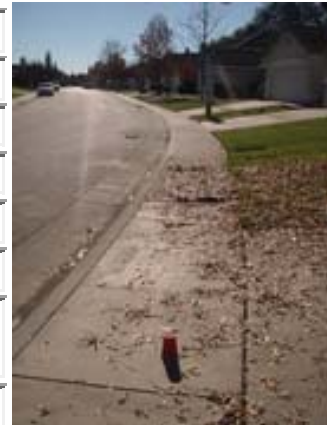
Field Date:	12/7/2010	Report Date:	12/7/2010	Barrier #:	3318
Location:	Aspen Gardens Wy - East				
X Coordinate:	-121.29909				
Y Coordinate:	38.68564				
Barrier Area:	Sidewalks				
Barrier Type:	Cross Slope - Existing (3.1% to 4.0%)				
Code Ref:	CBC 1133B.7.1.3 and ADA/ABA 403.3

As Built Meas:	364	Quantity:	LF		
Description:	Cross slope exceeds 2.0% (3.1% to 4.0%)				
As Built Desc:	3.8% cross slope				
Solution:	Demolish existing and construct new route				
Bar. Severity:	3 Hinderance	Cost Estimate:	\$45,500.00	Status:	
Implementation Priority:	4	Facility Function:			
Implementation Phase:		Implementation Date:			
Official Responsible:

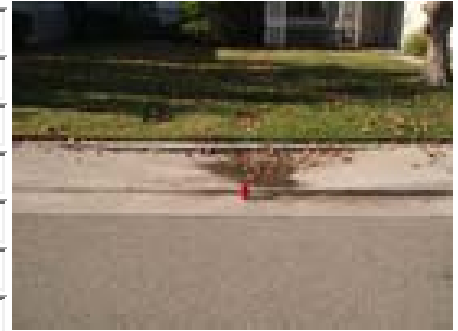
As Built Meas:	1	Quantity:	EACH	
Description:	No truncated domes provided at curb ramp			
As Built Desc:	No detectable warnings at curb ramp			
Solution:	Provide compliant truncated domes			
Bar. Severity:	2 Recommended	Cost Estimate:	\$1,400.00	Status:
Implementation Priority:	4	Facility Function:		
Implementation Phase:		Implementation Date:		
Official Responsible:

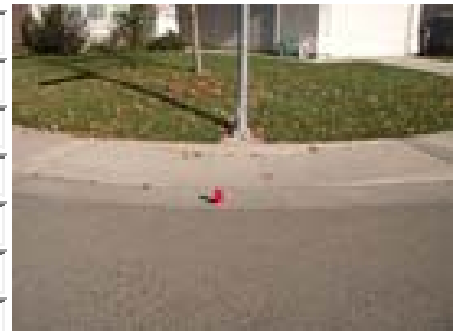
As Built Meas:	1	Quantity:	EACH	
Description:	No truncated domes provided at curb ramp			
As Built Desc:	No detectable warnings at curb ramp			
Solution:	Provide compliant truncated domes			
Bar. Severity:	2 Recommended	Cost Estimate:	\$1,400.00	Status:
Implementation Priority:	4	Facility Function:		
Implementation Phase:		Implementation Date:		
Official Responsible:

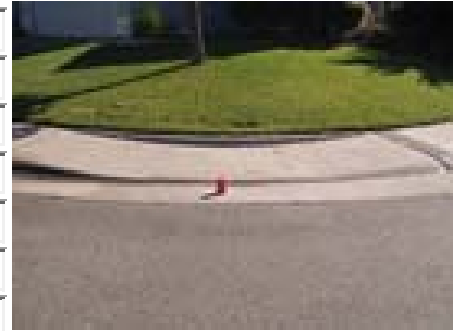
As Built Meas:	1	Quantity:	EACH	
Description:	No truncated domes provided at curb ramp			
As Built Desc:	No detectable warnings at curb ramp			
Solution:	Provide compliant truncated domes			
Bar. Severity:	2 Recommended	Cost Estimate:	\$1,400.00	Status:
Implementation Priority:	4	Facility Function:		
Implementation Phase:		Implementation Date:		
Official Responsible:

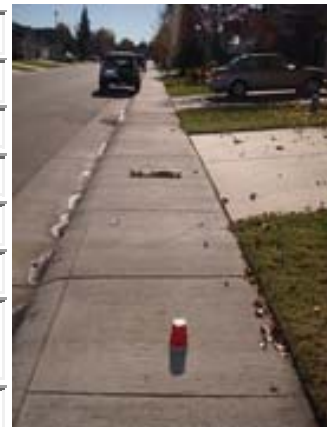
Field Date:	12/7/2010	Report Date:	12/7/2010	Barrier #:	3322
Location:	Aspen Gardens Wy - East				
X Coordinate:	-121.2991				
Y Coordinate:	38.68448				
Barrier Area:	Sidewalks				
Barrier Type:	Cross Slope - Existing (3.1% to 4.0%)				
Code Ref:	CBC 1133B.7.1.3 and ADA/ABA 403.3

As Built Meas:	600	Quantity:	LF	
Description:	Cross slope exceeds 2.0% (3.1% to 4.0%)			
As Built Desc:	3.2% cross slope			
Solution:	Demolish existing and construct new route			
Bar. Severity:	3 Hinderance	Cost Estimate:	\$75,000.00	Status:
Implementation Priority:	4	Facility Function:		
Implementation Phase:		Implementation Date:		
Official Responsible:

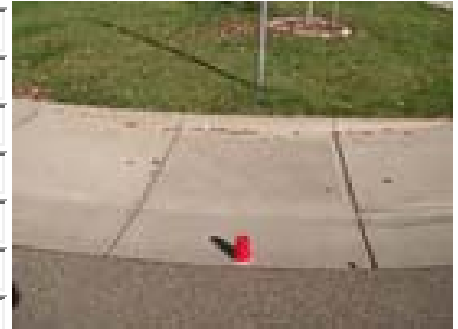
As Built Meas:	1	Quantity:	EACH		
Description:	No truncated domes provided at curb ramp				
As Built Desc:	No detectable warnings at curb ramp				
Solution:	Provide compliant truncated domes				
Bar. Severity:	2 Recommended	Cost Estimate:	\$1,400.00	Status:	
Implementation Priority:	4	Facility Function:			
Implementation Phase:		Implementation Date:			
Official Responsible:

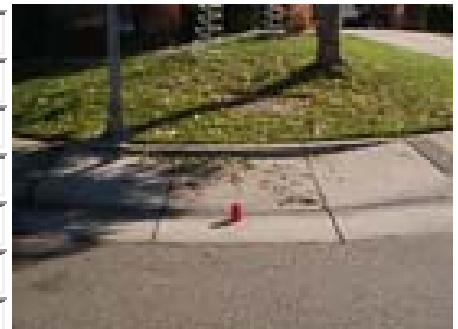
Field Date:	12/7/2010	Report Date:	12/7/2010	Barrier #:	3324A
Location:	Aspen Ranch Ct and Cedar Ranch Ct - Corner C				
X Coordinate:	-121.29892				
Y Coordinate:	38.68292				
Barrier Area:	Curb Ramps				
Barrier Type:	12" Grooves - Existing (3.1% to 4.0%)				
Code Ref:	CBC 1127B.5.6

As Built Meas:	1	Quantity:	EACH		
Description:	12" grooves at top of curb ramp are not level (3.1% to 4.0%)				
As Built Desc:	3.7% at 12" grooves				
Solution:	Demolish existing and construct new curb ramp				
Bar. Severity:	3 Hindrance	Cost Estimate:	\$2,500.00	Status:	
Implementation Priority:	4	Facility Function:			
Implementation Phase:		Implementation Date:			
Official Responsible:

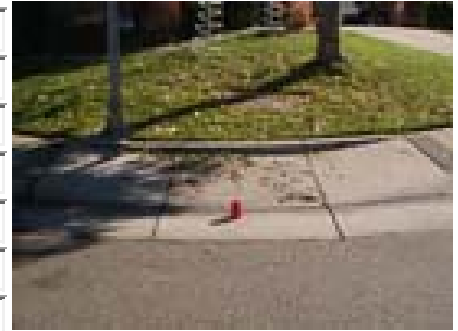
Field Date:	12/7/2010	Report Date:	12/7/2010	Barrier #:	3324B
Location:	Aspen Ranch Ct and Cedar Ranch Ct - Corner C				
X Coordinate:	-121.29892				
Y Coordinate:	38.68292				
Barrier Area:	Curb Ramps				
Barrier Type:	Detectable Warnings - Truncated Domes				
Code Ref:	CBC 1127B.5.7 and ADA/ABA 705.1.3

As Built Meas:	1	Quantity:	EACH		
Description:	No truncated domes provided at curb ramp				
As Built Desc:	No detectable warnings at curb ramp				
Solution:	Provide compliant truncated domes				
Bar. Severity:	2 Recommended	Cost Estimate:	\$0.00	Status:	
Implementation Priority:	4	Facility Function:			
Implementation Phase:		Implementation Date:			
Official Responsible:

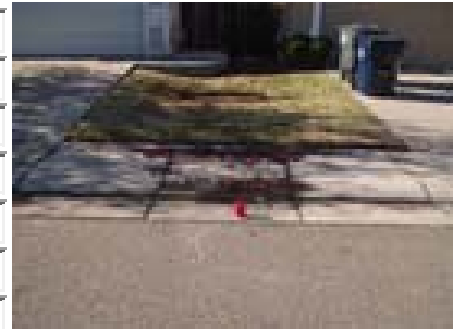
Field Date:	12/7/2010	Report Date:	12/7/2010	Barrier #:	3325
Location:	Aspen Ranch Ct and Cedar Ranch Ct - Corner D				
X Coordinate:	-121.29906				
Y Coordinate:	38.68286				
Barrier Area:	Curb Ramps				
Barrier Type:	Detectable Warnings - Truncated Domes				
Code Ref:	CBC 1127B.5.7 and ADA/ABA 705.1.3

As Built Meas:	1	Quantity:	EACH		
Description:	No truncated domes provided at curb ramp				
As Built Desc:	No detectable warnings at curb ramp				
Solution:	Provide compliant truncated domes				
Bar. Severity:	2 Recommended	Cost Estimate:	\$1,400.00	Status:	
Implementation Priority:	4	Facility Function:			
Implementation Phase:		Implementation Date:			
Official Responsible:

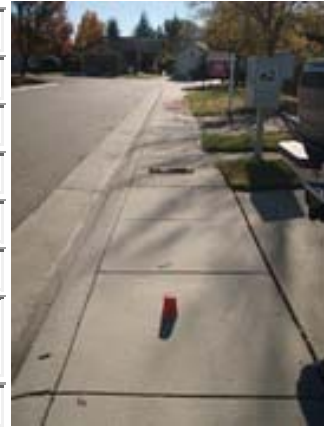
Field Date:	12/7/2010	Report Date:	12/7/2010	Barrier #:	3326
Location:	Aspen Ranch Ct - West				
X Coordinate:	-121.29904				
Y Coordinate:	38.68264				
Barrier Area:	Sidewalks				
Barrier Type:	Cross Slope - Existing (4.1% to 4.9%)				
Code Ref:	CBC 1133B.7.1.3 and ADA/ABA 403.3

As Built Meas:	177	Quantity:	LF		
Description:	Cross slope exceeds 2.0% (4.1% to 4.9%)				
As Built Desc:	4.2% cross slope				
Solution:	Demolish existing and construct new route				
Bar. Severity:	2 Recommended	Cost Estimate:	\$22,125.00	Status:	
Implementation Priority:	4	Facility Function:			
Implementation Phase:		Implementation Date:			
Official Responsible:

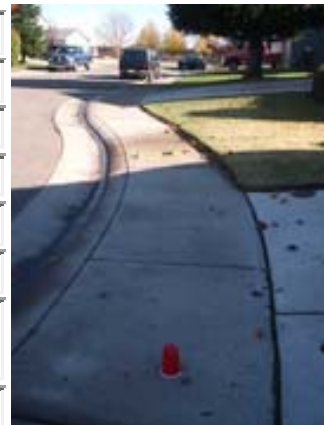
Field Date:	12/7/2010	Report Date:	12/7/2010	Barrier #:	3327
Location:	Aspen Ranch Ct - South				
X Coordinate:	-121.29891				
Y Coordinate:	38.68215				
Barrier Area:	Sidewalks				
Barrier Type:	Cross Slope - Existing (3.1% to 4.0%)				
Code Ref:	CBC 1133B.7.1.3 and ADA/ABA 403.3

As Built Meas:	235	Quantity:	LF		
Description:	Cross slope exceeds 2.0% (3.1% to 4.0%)				
As Built Desc:	3.7% cross slope				
Solution:	Demolish existing and construct new route				
Bar. Severity:	3 Hinderance	Cost Estimate:	\$29,375.00	Status:	
Implementation Priority:	4	Facility Function:			
Implementation Phase:		Implementation Date:			
Official Responsible:

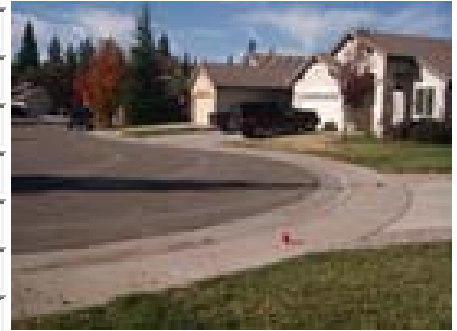
Field Date:	12/7/2010	Report Date:	12/7/2010	Barrier #:	3328
Location:	Aspen Ranch Ct - North				
X Coordinate:	-121.29815				
Y Coordinate:	38.6823				
Barrier Area:	Sidewalks				
Barrier Type:	Cross Slope - Existing (3.1% to 4.0%)				
Code Ref:	CBC 1133B.7.1.3 and ADA/ABA 403.3

As Built Meas:	232	Quantity:	LF	
Description:	Cross slope exceeds 2.0% (3.1% to 4.0%)			
As Built Desc:	3.1% cross slope			
Solution:	Demolish existing and construct new route			
Bar. Severity:	3 Hinderance	Cost Estimate:	\$29,000.00	Status:
Implementation Priority:	4	Facility Function:		
Implementation Phase:		Implementation Date:		
Official Responsible:

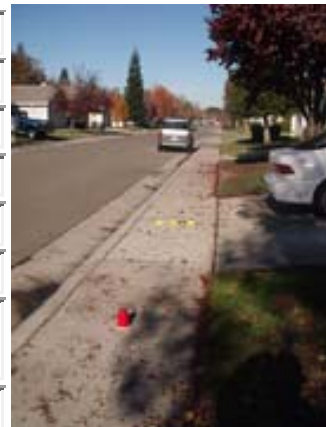
Field Date:	12/7/2010	Report Date:	12/7/2010	Barrier #:	3329
Location:	Aspen Ranch Ct - East				
X Coordinate:	-121.29887				
Y Coordinate:	38.68245				
Barrier Area:	Sidewalks				
Barrier Type:	Cross Slope - Existing (3.1% to 4.0%)				
Code Ref:	CBC 1133B.7.1.3 and ADA/ABA 403.3

As Built Meas:	173	Quantity:	LF	
Description:	Cross slope exceeds 2.0% (3.1% to 4.0%)			
As Built Desc:	3.2% cross slope			
Solution:	Demolish existing and construct new route			
Bar. Severity:	3 Hinderance	Cost Estimate:	\$21,625.00	Status:
Implementation Priority:	4	Facility Function:		
Implementation Phase:		Implementation Date:		
Official Responsible:

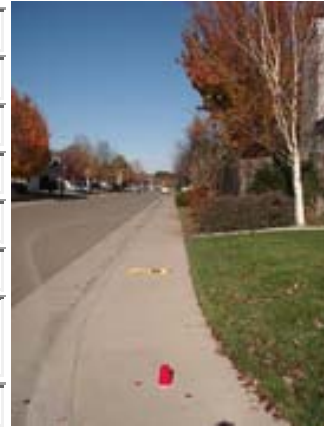
Field Date:	12/7/2010	Report Date:	12/7/2010	Barrier #:	3330
Location:	Aspen Ranch Ct - East				
X Coordinate:	-121.29895				
Y Coordinate:	38.68314				
Barrier Area:	Sidewalks				
Barrier Type:	Cross Slope - Existing (3.1% to 4.0%)				
Code Ref:	CBC 1133B.7.1.3 and ADA/ABA 403.3

As Built Meas:	537	Quantity:	LF	
Description:	Cross slope exceeds 2.0% (3.1% to 4.0%)			
As Built Desc:	3.7% cross slope			
Solution:	Demolish existing and construct new route			
Bar. Severity:	3 Hinderance	Cost Estimate:	\$67,125.00	Status:
Implementation Priority:	4	Facility Function:		
Implementation Phase:		Implementation Date:		
Official Responsible:

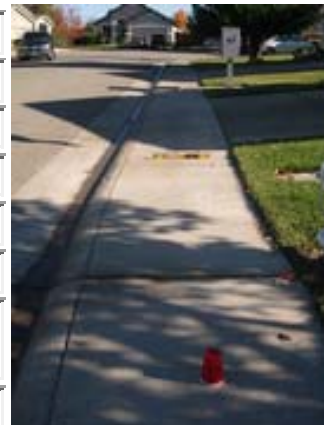
Field Date:	12/7/2010	Report Date:	12/7/2010	Barrier #:	3331
Location:	Aspen View Ct - South				
X Coordinate:	-121.2989				
Y Coordinate:	38.68454				
Barrier Area:	Sidewalks				
Barrier Type:	Cross Slope - Existing (3.1% to 4.0%)				
Code Ref:	CBC 1133B.7.1.3 and ADA/ABA 403.3

As Built Meas:	186	Quantity:	LF	
Description:	Cross slope exceeds 2.0% (3.1% to 4.0%)			
As Built Desc:	3.5% cross slope			
Solution:	Demolish existing and construct new route			
Bar. Severity:	3 Hinderance	Cost Estimate:	\$23,250.00	Status:
Implementation Priority:	4	Facility Function:		
Implementation Phase:		Implementation Date:		
Official Responsible:

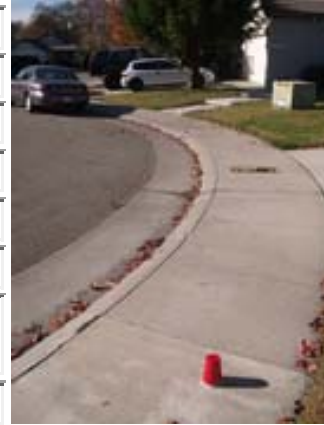
Field Date:	12/7/2010	Report Date:	12/7/2010	Barrier #:	3332
Location:	Aspen View Ct - North				
X Coordinate:	-121.29837				
Y Coordinate:	38.68476				
Barrier Area:	Sidewalks				
Barrier Type:	Cross Slope - Existing (3.1% to 4.0%)				
Code Ref:	CBC 1133B.7.1.3 and ADA/ABA 403.3

As Built Meas:	166	Quantity:	LF		
Description:	Cross slope exceeds 2.0% (3.1% to 4.0%)				
As Built Desc:	3.2% cross slope				
Solution:	Demolish existing and construct new route				
Bar. Severity:	3 Hinderance	Cost Estimate:	\$20,750.00	Status:	
Implementation Priority:	4	Facility Function:			
Implementation Phase:		Implementation Date:			
Official Responsible:

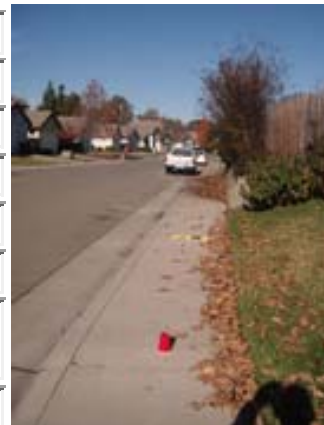
Field Date:	12/7/2010	Report Date:	12/7/2010	Barrier #:	3333
Location:	Aspen Gardens Wy - East				
X Coordinate:	-121.29901				
Y Coordinate:	38.68475				
Barrier Area:	Sidewalks				
Barrier Type:	Cross Slope - Existing (3.1% to 4.0%)				
Code Ref:	CBC 1133B.7.1.3 and ADA/ABA 403.3

As Built Meas:	337	Quantity:	LF		
Description:	Cross slope exceeds 2.0% (3.1% to 4.0%)				
As Built Desc:	3.2% cross slope				
Solution:	Demolish existing and construct new route				
Bar. Severity:	3 Hinderance	Cost Estimate:	\$42,125.00	Status:	
Implementation Priority:	4	Facility Function:			
Implementation Phase:		Implementation Date:			
Official Responsible:

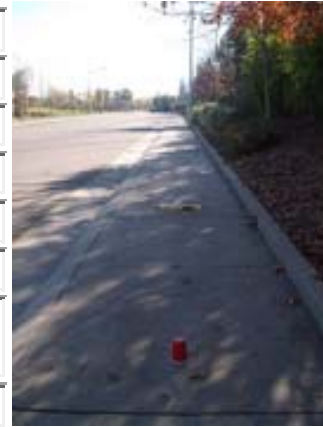
Field Date:	12/7/2010	Report Date:	12/7/2010	Barrier #:	3334
Location:	Stock Ranch Rd - South				
X Coordinate:	-121.29759				
Y Coordinate:	38.68603				
Barrier Area:	Sidewalks				
Barrier Type:	Cross Slope - Existing (4.1% to 4.9%)				
Code Ref:	CBC 1133B.7.1.3 and ADA/ABA 403.3

As Built Meas:	456	Quantity:	LF	
Description:	Cross slope exceeds 2.0% (4.1% to 4.9%)			
As Built Desc:	4.1% cross slope			
Solution:	Demolish existing and construct new route			
Bar. Severity:	2 Recommended	Cost Estimate:	\$57,000.00	Status:
Implementation Priority:	4	Facility Function:		
Implementation Phase:		Implementation Date:		
Official Responsible:

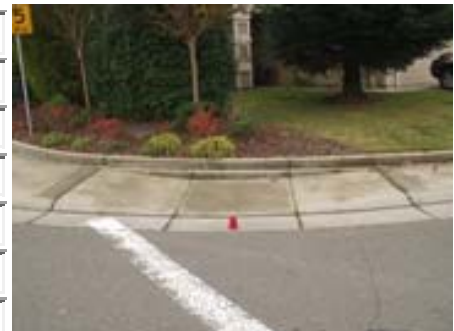
Field Date:	12/10/2010	Report Date:	12/10/2010	Barrier #:	3335A
Location:	Stock Ranch Rd and Cedar Ranch Dr - Corner C				
X Coordinate:	-121.29692				
Y Coordinate:	38.68468				
Barrier Area:	Curb Ramps				
Barrier Type:	12" Grooves - Existing (2.1% to 3.0%)				
Code Ref:	CBC 1127B.5.6

As Built Meas:	1	Quantity:	EACH	
Description:	12" grooves at top of curb ramp are not level (2.1% to 3.0%)			
As Built Desc:	2.5% at 12" grooves			
Solution:	Demolish existing and construct new curb ramp			
Bar. Severity:	4 Low Severity	Cost Estimate:	\$2,500.00	Status:
Implementation Priority:	4	Facility Function:		
Implementation Phase:		Implementation Date:		
Official Responsible:

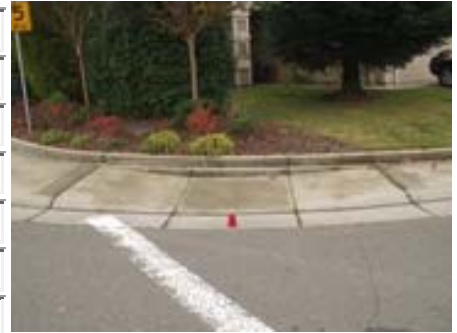
Field Date:	12/10/2010	Report Date:	12/10/2010	Barrier #:	3335B
Location:	Stock Ranch Rd and Cedar Ranch Dr - Corner C				
X Coordinate:	-121.29692				
Y Coordinate:	38.68468				
Barrier Area:	Curb Ramps				
Barrier Type:	Parallel Ramp Landing - Existing (3.1% to 4.0%)				
Code Ref:	CBC 1127B.5.4 and ADA/ABA 406.4

As Built Meas:	1	Quantity:	EACH		
Description:	Curb ramp landing or pan not level (3.1% to 4.0%)				
As Built Desc:	3.5% landing slope				
Solution:	Demolish existing and construct new transition				
Bar. Severity:	3 Hindrance	Cost Estimate:	\$0.00	Status:	
Implementation Priority:	4	Facility Function:			
Implementation Phase:		Implementation Date:			
Official Responsible:

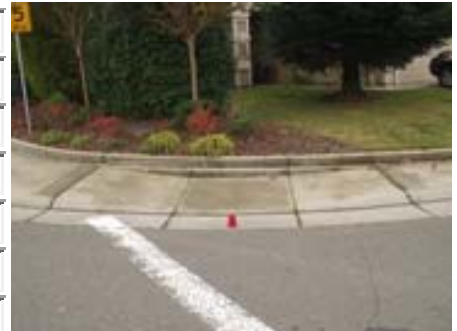
Field Date:	12/10/2010	Report Date:	12/10/2010	Barrier #:	3335C
Location:	Stock Ranch Rd and Cedar Ranch Dr - Corner C				
X Coordinate:	-121.29692				
Y Coordinate:	38.68468				
Barrier Area:	Curb Ramps				
Barrier Type:	Running Slope - Existing (8.6% to 8.9%)				
Code Ref:	CBC 1127B.5.3 and ADA/ABA 406.1

As Built Meas:	1	Quantity:	EACH		
Description:	Ramp run cross slope exceeds 2.0% (8.6% to 8.9%)				
As Built Desc:	8.9% running slope				
Solution:	Demolish existing and construct new curb ramp				
Bar. Severity:	3 Hindrance	Cost Estimate:	\$0.00	Status:	
Implementation Priority:	4	Facility Function:			
Implementation Phase:		Implementation Date:			
Official Responsible:

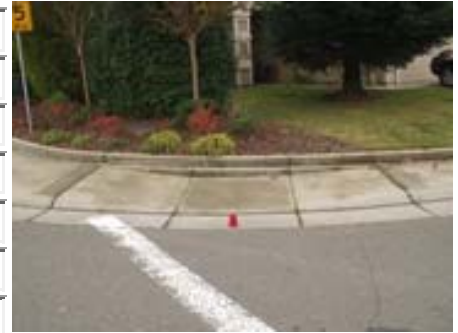
Barrier Type: Detectable Warnings - Truncated Domes

Code Ref: CBC 1127B.5.7 and ADA/ABA 705.1.3

As Built Meas: 1 Quantity: EACH

Description: No truncated domes provided at curb ramp

Bar. Severity: 2 Recommended Cost Estimate: \$0.00 Status:

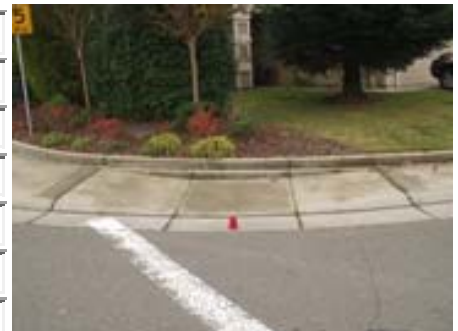
Barrier Type: Gutter Slope - Existing (8.3% or more)

Code Ref: CBC 1127B.5.3 and ADA/ABA 406.2

As Built Meas: 6 Quantity: SF

Description: Gutter slope exceeds 5.0% (8.3% or more)

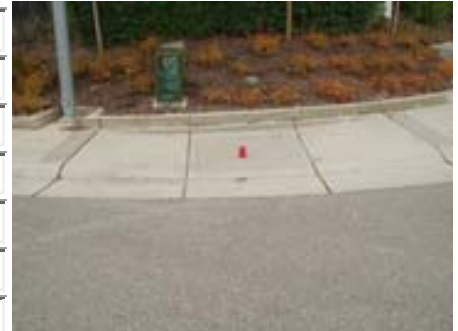
Field Date:	12/10/2010	Report Date:	12/10/2010	Barrier #:	3336A
Location:	Stock Ranch Rd and Cedar Ranch Dr - Corner D				
X Coordinate:	-121.297				
Y Coordinate:	38.68481				
Barrier Area:	Curb Ramps				
Barrier Type:	Parallel Ramp Landing - Existing (2.1% to 3.0%)				
Code Ref:	CBC 1127B.5.4 and ADA/ABA 406.4

As Built Meas:	1	Quantity:	EACH		
Description:	Curb ramp landing or pan not level (2.1% to 3.0%)				
As Built Desc:	3.0% landing slope				
Solution:	Demolish existing and construct new transition				
Bar. Severity:	4 Low Severity	Cost Estimate:	\$2,500.00	Status:	
Implementation Priority:	4	Facility Function:			
Implementation Phase:		Implementation Date:			
Official Responsible:

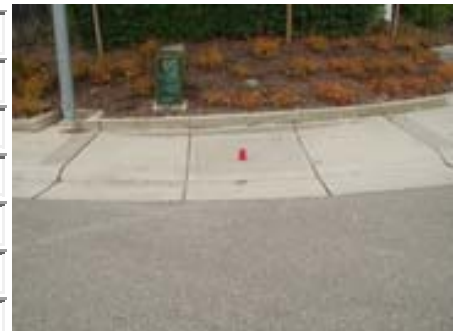
Field Date:	12/10/2010	Report Date:	12/10/2010	Barrier #:	3336B
Location:	Stock Ranch Rd and Cedar Ranch Dr - Corner D				
X Coordinate:	-121.297				
Y Coordinate:	38.68481				
Barrier Area:	Curb Ramps				
Barrier Type:	12" Grooves - Existing (3.1% to 4.0%)				
Code Ref:	CBC 1127B.5.6

As Built Meas:	1	Quantity:	EACH		
Description:	12" grooves at top of curb ramp are not level (3.1% to 4.0%)				
As Built Desc:	3.1% at 12" grooves				
Solution:	Demolish existing and construct new curb ramp				
Bar. Severity:	3 Hindrance	Cost Estimate:	\$0.00	Status:	
Implementation Priority:	4	Facility Function:			
Implementation Phase:		Implementation Date:			
Official Responsible:

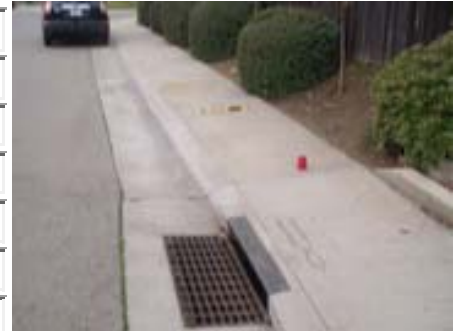
Field Date:	12/10/2010	Report Date:	12/10/2010	Barrier #:	3337
Location:	Cedar Ranch Dr - West				
X Coordinate:	-121.29715				
Y Coordinate:	38.6847				
Barrier Area:	Sidewalks				
Barrier Type:	Cross Slope - Existing (3.1% to 4.0%)				
Code Ref:	CBC 1133B.7.1.3 and ADA/ABA 403.3

As Built Meas:	64	Quantity:	LF		
Description:	Cross slope exceeds 2.0% (3.1% to 4.0%)				
As Built Desc:	3.5% cross slope				
Solution:	Demolish existing and construct new route				
Bar. Severity:	3 Hindrance	Cost Estimate:	\$8,000.00	Status:	
Implementation Priority:	4	Facility Function:			
Implementation Phase:		Implementation Date:			
Official Responsible:

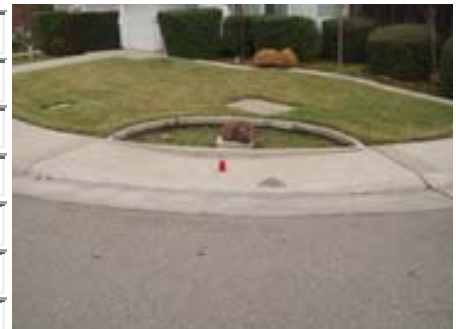
Field Date:	12/10/2010	Report Date:	12/10/2010	Barrier #:	3338A
Location:	Cedar Ranch Cr and Ryan Taylor Wy - Corner A				
X Coordinate:	-121.2973				
Y Coordinate:	38.68462				
Barrier Area:	Curb Ramps				
Barrier Type:	Running Slope - Existing (8.6% to 8.9%)				
Code Ref:	CBC 1127B.5.3 and ADA/ABA 406.1

As Built Meas:	1	Quantity:	EACH		
Description:	Ramp run cross slope exceeds 2.0% (8.6% to 8.9%)				
As Built Desc:	8.9% running slope				
Solution:	Demolish existing and construct new curb ramp				
Bar. Severity:	3 Hindrance	Cost Estimate:	\$2,500.00	Status:	
Implementation Priority:	4	Facility Function:			
Implementation Phase:		Implementation Date:			
Official Responsible:

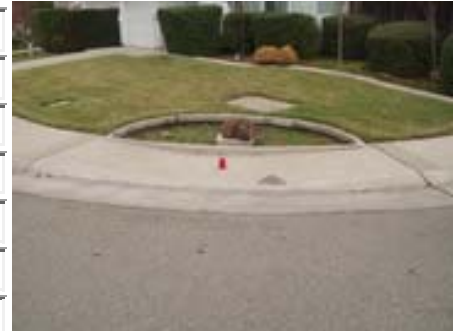
Field Date:	12/10/2010	Report Date:	12/10/2010	Barrier #:	3338B
Location:	Cedar Ranch Cr and Ryan Taylor Wy - Corner A				
X Coordinate:	-121.2973				
Y Coordinate:	38.68462				
Barrier Area:	Curb Ramps				
Barrier Type:	Detectable Warnings - Truncated Domes				
Code Ref:	CBC 1127B.5.7 and ADA/ABA 705.1.3

As Built Meas:	1	Quantity:	EACH	
Description:	No truncated domes provided at curb ramp			
As Built Desc:	No detectable warnings at curb ramp			
Solution:	Provide compliant truncated domes			
Bar. Severity:	2 Recommended	Cost Estimate:	\$0.00	Status:
Implementation Priority:	4	Facility Function:		
Implementation Phase:		Implementation Date:		
Official Responsible:

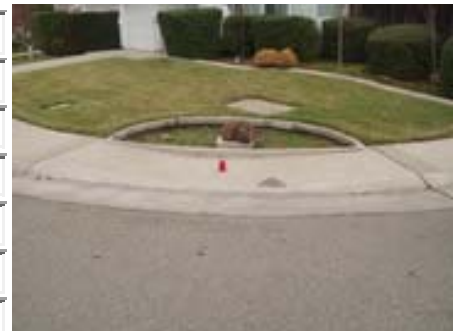
Field Date:	12/10/2010	Report Date:	12/10/2010	Barrier #:	3338C
Location:	Cedar Ranch Cr and Ryan Taylor Wy - Corner A				
X Coordinate:	-121.2973				
Y Coordinate:	38.68462				
Barrier Area:	Curb Ramps				
Barrier Type:	Gutter Slope - Existing (5.9% - 6.5%)				
Code Ref:	CBC 1127B.5.3 and ADA/ABA 406.2

As Built Meas:	6	Quantity:	SF	
Description:	Gutter slope exceeds 5.0% (5.9% - 6.5%)			
As Built Desc:	6.4% gutter slope			
Solution:	Demolish existing and construct new gutter			
Bar. Severity:	3 Hindrance	Cost Estimate:	\$0.00	Status:
Implementation Priority:	4	Facility Function:		
Implementation Phase:		Implementation Date:		
Official Responsible:

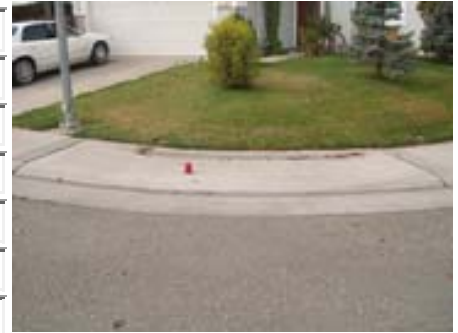
Field Date:	12/10/2010	Report Date:	12/10/2010	Barrier #:	3339A
Location:	Cedar Ranch Cr and Ryan Taylor Wy - Corner D				
X Coordinate:	-121.29738				
Y Coordinate:	38.68454				
Barrier Area:	Curb Ramps				
Barrier Type:	12" Grooves - Existing (4.1% to 4.9%)				
Code Ref:	CBC 1127B.5.6

As Built Meas:	1	Quantity:	EACH	
Description:	12" grooves at top of curb ramp are not level (4.1% to 4.9%)			
As Built Desc:	4.1% at 12" grooves			
Solution:	Demolish existing and construct new curb ramp			
Bar. Severity:	2 Recommended	Cost Estimate:	\$2,500.00	Status:
Implementation Priority:	4	Facility Function:		
Implementation Phase:		Implementation Date:		
Official Responsible:

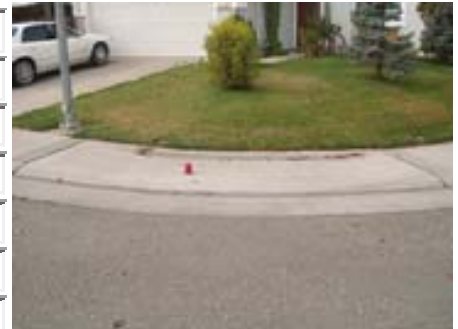
Field Date:	12/10/2010	Report Date:	12/10/2010	Barrier #:	3339B
Location:	Cedar Ranch Cr and Ryan Taylor Wy - Corner D				
X Coordinate:	-121.29738				
Y Coordinate:	38.68454				
Barrier Area:	Curb Ramps				
Barrier Type:	Parallel Ramp Landing - Existing (2.1% to 3.0%)				
Code Ref:	CBC 1127B.5.4 and ADA/ABA 406.4

As Built Meas:	1	Quantity:	EACH	
Description:	Curb ramp landing or pan not level (2.1% to 3.0%)			
As Built Desc:	2.7% landing slope			
Solution:	Demolish existing and construct new transition			
Bar. Severity:	4 Low Severity	Cost Estimate:	\$0.00	Status:
Implementation Priority:	4	Facility Function:		
Implementation Phase:		Implementation Date:		
Official Responsible:

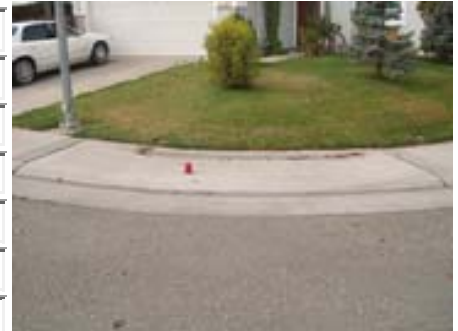
Field Date:	12/10/2010	Report Date:	12/10/2010	Barrier #:	3339C
Location:	Cedar Ranch Cr and Ryan Taylor Wy - Corner D				
X Coordinate:	-121.29738				
Y Coordinate:	38.68454				
Barrier Area:	Curb Ramps				
Barrier Type:	Running Slope - Existing (9.5% or more)				
Code Ref:	CBC 1127B.5.3 and ADA/ABA 406.1

As Built Meas:	1	Quantity:	EACH	
Description:	Ramp run cross slope exceeds 2.0% (9.5% or more)			
As Built Desc:	9.5% running slope			
Solution:	Demolish existing and construct new curb ramp			
Bar. Severity:	1 Necessary	Cost Estimate:	\$0.00	Status:
Implementation Priority:	4	Facility Function:		
Implementation Phase:		Implementation Date:		
Official Responsible:

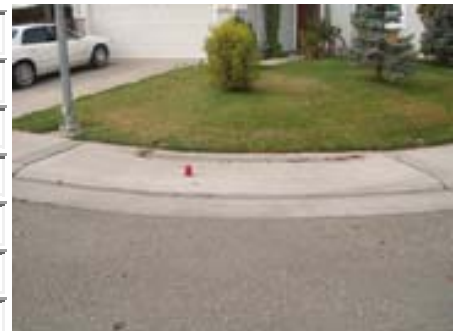
Field Date:	12/10/2010	Report Date:	12/10/2010	Barrier #:	3339D
Location:	Cedar Ranch Cr and Ryan Taylor Wy - Corner D				
X Coordinate:	-121.29738				
Y Coordinate:	38.68454				
Barrier Area:	Curb Ramps				
Barrier Type:	Detectable Warnings - Truncated Domes				
Code Ref:	CBC 1127B.5.7 and ADA/ABA 705.1.3

As Built Meas:	1	Quantity:	EACH	
Description:	No truncated domes provided at curb ramp			
As Built Desc:	No detectable warnings at curb ramp			
Solution:	Provide compliant truncated domes			
Bar. Severity:	2 Recommended	Cost Estimate:	\$0.00	Status:
Implementation Priority:	4	Facility Function:		
Implementation Phase:		Implementation Date:		
Official Responsible:

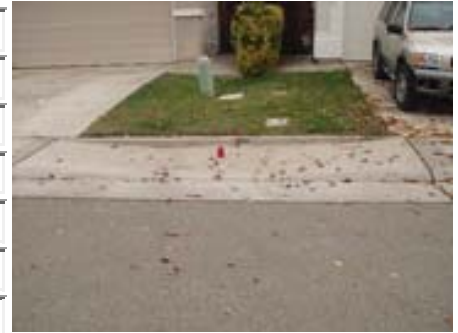
Barrier Type: Detectable Warnings - Truncated Domes

Code Ref: CBC 1127B.5.7 and ADA/ABA 705.1.3

As Built Meas: 1 Quantity: EACH

Description: No truncated domes provided at curb ramp

Bar. Severity: 2 Recommended Cost Estimate: \$1,400.00 Status:

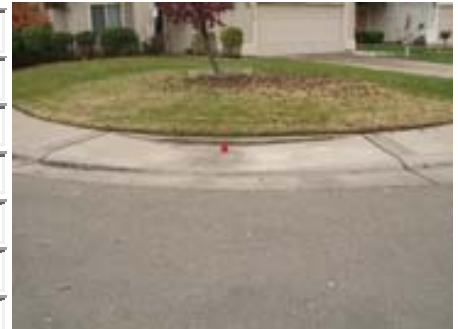
Barrier Type: Detectable Warnings - Truncated Domes

Code Ref: CBC 1127B.5.7 and ADA/ABA 705.1.3

As Built Meas: 1 Quantity: EACH

Description: No truncated domes provided at curb ramp

Bar. Severity: 2 Recommended Cost Estimate: \$1,400.00 Status:

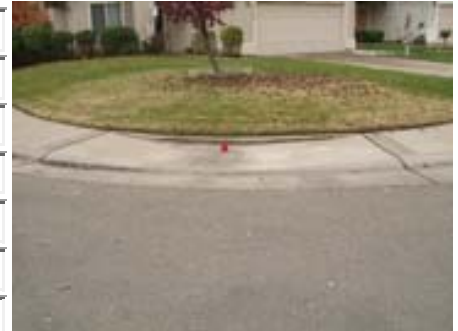
Field Date:	12/10/2010	Report Date:	12/10/2010	Barrier #:	3341B
Location:	Ryan Taylor Wy and Cedar Park Ct - Corner C				
X Coordinate:	-121.29791				
Y Coordinate:	38.6854				
Barrier Area:	Curb Ramps				
Barrier Type:	Gutter Slope - Existing (6.6% to 8.2%)				
Code Ref:	CBC 1127B.5.3 and ADA/ABA 406.2

As Built Meas:	6	Quantity:	SF	
Description:	Gutter slope exceeds 5.0% (6.6% to 8.2%)			
As Built Desc:	6.6% gutter slope			
Solution:	Demolish existing and construct new gutter			
Bar. Severity:	2 Recommended	Cost Estimate:	\$750.00	Status:
Implementation Priority:	4	Facility Function:		
Implementation Phase:		Implementation Date:		
Official Responsible:

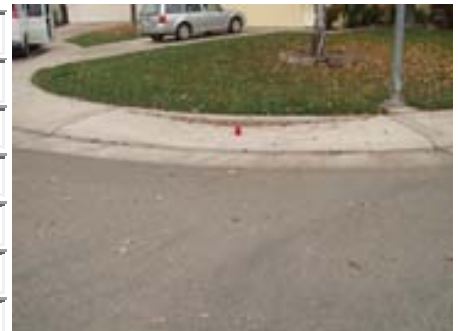
Field Date:	12/10/2010	Report Date:	12/10/2010	Barrier #:	3342A
Location:	Ryan Taylor Wy and Cedar Park Ct - Corner D				
X Coordinate:	-121.29797				
Y Coordinate:	38.68549				
Barrier Area:	Curb Ramps				
Barrier Type:	Detectable Warnings - Truncated Domes				
Code Ref:	CBC 1127B.5.7 and ADA/ABA 705.1.3

As Built Meas:	1	Quantity:	EACH	
Description:	No truncated domes provided at curb ramp			
As Built Desc:	No detectable warnings at curb ramp			
Solution:	Provide compliant truncated domes			
Bar. Severity:	2 Recommended	Cost Estimate:	\$1,400.00	Status:
Implementation Priority:	4	Facility Function:		
Implementation Phase:		Implementation Date:		
Official Responsible:

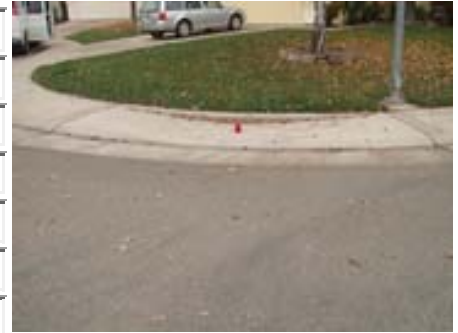
Field Date:	12/10/2010	Report Date:	12/10/2010	Barrier #:	3342B
Location:	Ryan Taylor Wy and Cedar Park Ct - Corner D				
X Coordinate:	-121.29797				
Y Coordinate:	38.68549				
Barrier Area:	Curb Ramps				
Barrier Type:	Lip - Gutter to Asphalt Transition				
Code Ref:	CBC 1127B.5.3 and ADA/ABA 303.3

As Built Meas:	1	Quantity:	EACH		
Description:	Transition at transition into asphalt not flush and free of any lip				
As Built Desc:	1/2" lip at asphalt transition into roadway				
Solution:	Remove lip to create flush transition				
Bar. Severity:	1 Necessary	Cost Estimate:	\$250.00	Status:	
Implementation Priority:	4	Facility Function:			
Implementation Phase:		Implementation Date:			
Official Responsible:

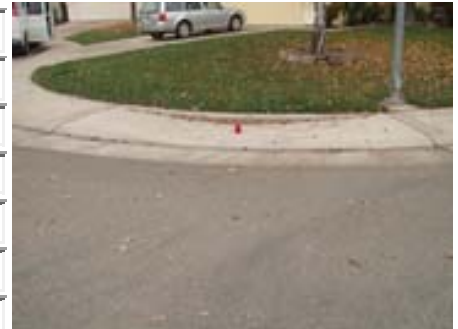
Field Date:	12/10/2010	Report Date:	12/10/2010	Barrier #:	3342C
Location:	Ryan Taylor Wy and Cedar Park Ct - Corner D				
X Coordinate:	-121.29797				
Y Coordinate:	38.68549				
Barrier Area:	Curb Ramps				
Barrier Type:	Gutter Slope - Existing (5.1% - 5.8%)				
Code Ref:	CBC 1127B.5.3 and ADA/ABA 406.2

As Built Meas:	6	Quantity:	SF		
Description:	Gutter slope exceeds 5.0% (5.1% - 5.8%)				
As Built Desc:	5.8% gutter slope				
Solution:	Demolish existing and construct new gutter				
Bar. Severity:	4 Low Severity	Cost Estimate:	\$750.00	Status:	
Implementation Priority:	4	Facility Function:			
Implementation Phase:		Implementation Date:			
Official Responsible:

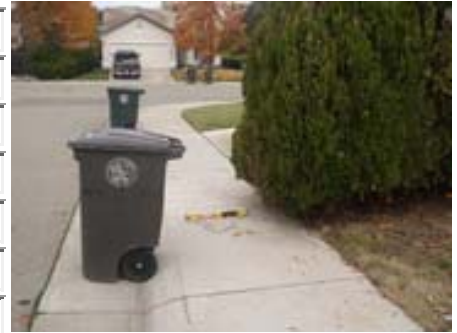
Field Date:	12/10/2010	Report Date:	12/10/2010	Barrier #:	3343
Location:	Ryan Taylor Wy - North				
X Coordinate:	-121.29806				
Y Coordinate:	38.686				
Barrier Area:	Sidewalks				
Barrier Type:	Clear Width - Existing ( $\leq 31"$ or less)				
Code Ref:	CBC 1133B.7.1

As Built Meas:	2	Quantity:	LF	
Description:	Pedestrian route is not min. 48" wide ( $\leq 31"$ or less)			
As Built Desc:	30" clear width due to foliage			
Solution:	Trim foliage			
Bar. Severity:	1 Necessary	Cost Estimate:	\$125.00	Status:
Implementation Priority:	4	Facility Function:		
Implementation Phase:		Implementation Date:		
Official Responsible:

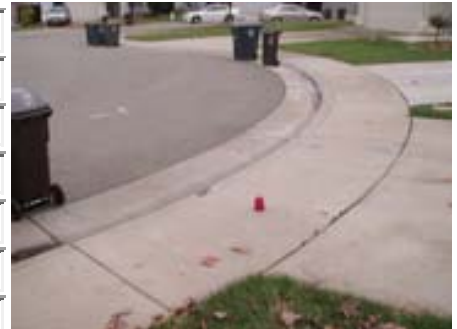
Field Date:	12/10/2010	Report Date:	12/10/2010	Barrier #:	3344
Location:	Cedar Park Ct - South				
X Coordinate:	-121.29828				
Y Coordinate:	38.68535				
Barrier Area:	Sidewalks				
Barrier Type:	Cross Slope - Existing (3.1% to 4.0%)				
Code Ref:	CBC 1133B.7.1.3 and ADA/ABA 403.3

As Built Meas:	121	Quantity:	LF	
Description:	Cross slope exceeds 2.0% (3.1% to 4.0%)			
As Built Desc:	3.7% cross slope			
Solution:	Demolish existing and construct new route			
Bar. Severity:	3 Hinderance	Cost Estimate:	\$15,125.00	Status:
Implementation Priority:	4	Facility Function:		
Implementation Phase:		Implementation Date:		
Official Responsible:

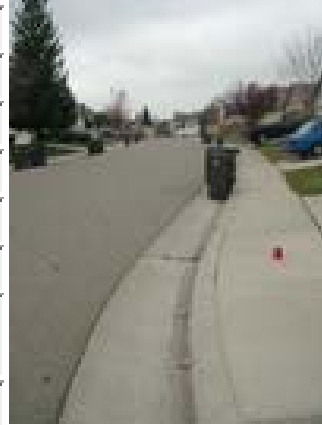
Field Date:	12/10/2010	Report Date:	12/10/2010	Barrier #:	3345
Location:	Cedar Ranch Dr - West				
X Coordinate:	-121.29738				
Y Coordinate:	38.68449				
Barrier Area:	Sidewalks				
Barrier Type:	Cross Slope - Existing (3.1% to 4.0%)				
Code Ref:	CBC 1133B.7.1.3 and ADA/ABA 403.3

As Built Meas:	121	Quantity:	LF	
Description:	Cross slope exceeds 2.0% (3.1% to 4.0%)			
As Built Desc:	3.7% cross slope			
Solution:	Demolish existing and construct new route			
Bar. Severity:	3 Hinderance	Cost Estimate:	\$15,125.00	Status:
Implementation Priority:	4	Facility Function:		
Implementation Phase:		Implementation Date:		
Official Responsible:
