**DRAFT ADA TRANSITION PLAN UPDATE  
NEIGHBORHOOD AREA 4 ARCADE CREEK  
SEPTEMBER 20, 2011**

CITY OF CITRUS HEIGHTS

## Arcade Creek Neighborhood Area

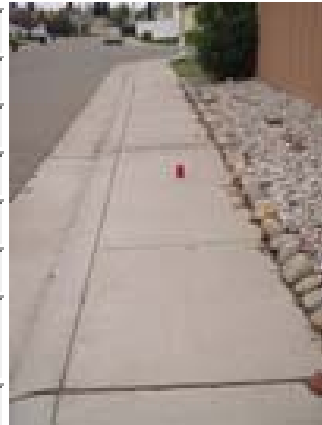
Field Date:	12/10/2010	Report Date:	12/10/2010	Barrier #:	3346
Location:	Cedar Ranch Dr - West				
X Coordinate:	-121.2979				
Y Coordinate:	38.68385				
Barrier Area:	Sidewalks				
Barrier Type:	Cross Slope - Existing (3.1% to 4.0%)				
Code Ref:	CBC 1133B.7.1.3 and ADA/ABA 403.3

As Built Meas:	48	Quantity:	LF	
Description:	Cross slope exceeds 2.0% (3.1% to 4.0%)			
As Built Desc:	3.5% cross slope			
Solution:	Demolish existing and construct new route			
Bar. Severity:	3 Hinderance	Cost Estimate:	\$6,000.00	Status:
Implementation Priority:	4	Facility Function:		
Implementation Phase:		Implementation Date:		
Official Responsible:

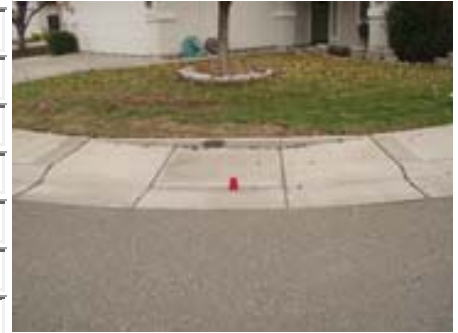
Barrier Type: Detectable Warnings - Truncated Domes

Code Ref: CBC 1127B.5.7 and ADA/ABA 705.1.3

As Built Meas: 1 Quantity: EACH

Description: No truncated domes provided at curb ramp

Bar. Severity: 2 Recommended Cost Estimate: \$1,400.00 Status:

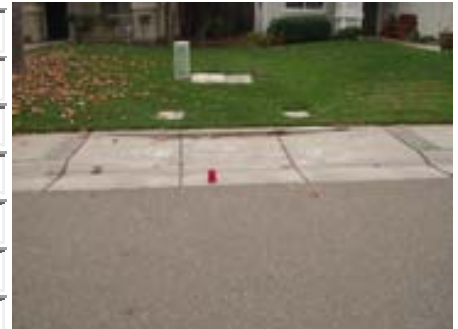
Barrier Type: Gutter Slope - Existing (5.9% - 6.5%)

Code Ref: CBC 1127B.5.3 and ADA/ABA 406.2

As Built Meas: 6 Quantity: SF

Description: Gutter slope exceeds 5.0% (5.9% - 6.5%)

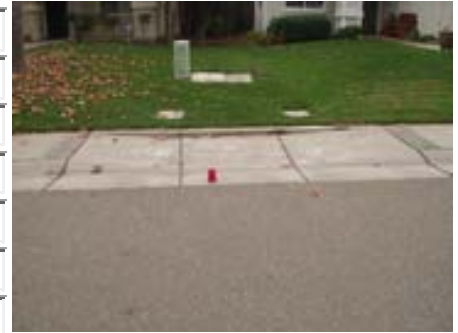
Field Date:	12/10/2010	Report Date:	12/10/2010	Barrier #:	3348A
Location:	Cedar Ranch Dr and Cedar Garden Ct - Corner B				
X Coordinate:	-121.29793				
Y Coordinate:	38.68372				
Barrier Area:	Curb Ramps				
Barrier Type:	Detectable Warnings - Truncated Domes				
Code Ref:	CBC 1127B.5.7 and ADA/ABA 705.1.3

As Built Meas:	1	Quantity:	EACH	
Description:	No truncated domes provided at curb ramp			
As Built Desc:	No detectable warnings at curb ramp			
Solution:	Provide compliant truncated domes			
Bar. Severity:	2 Recommended	Cost Estimate:	\$1,400.00	Status:
Implementation Priority:	4	Facility Function:		
Implementation Phase:		Implementation Date:		
Official Responsible:

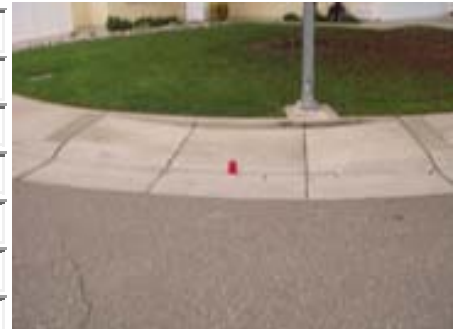
Field Date:	12/10/2010	Report Date:	12/10/2010	Barrier #:	3348B
Location:	Cedar Ranch Dr and Cedar Garden Ct - Corner B				
X Coordinate:	-121.29793				
Y Coordinate:	38.68372				
Barrier Area:	Curb Ramps				
Barrier Type:	Gutter Slope - Existing (6.6% to 8.2%)				
Code Ref:	CBC 1127B.5.3 and ADA/ABA 406.2

As Built Meas:	6	Quantity:	SF	
Description:	Gutter slope exceeds 5.0% (6.6% to 8.2%)			
As Built Desc:	8.5% gutter slope			
Solution:	Demolish existing and construct new gutter			
Bar. Severity:	2 Recommended	Cost Estimate:	\$750.00	Status:
Implementation Priority:	4	Facility Function:		
Implementation Phase:		Implementation Date:		
Official Responsible:

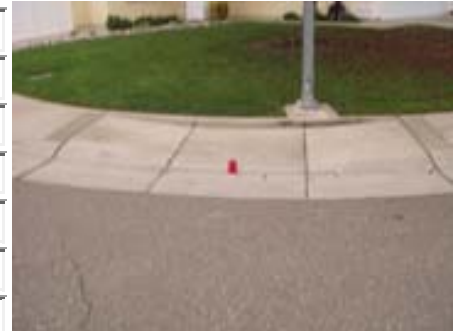
Barrier Type: Detectable Warnings - Truncated Domes

Code Ref: CBC 1127B.5.7 and ADA/ABA 705.1.3

As Built Meas: 1 Quantity: EACH

Description: No truncated domes provided at curb ramp

Bar. Severity: 2 Recommended Cost Estimate: \$1,400.00 Status:

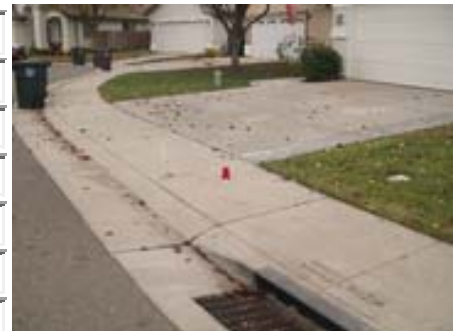
Barrier Type: Cross Slope - Existing (4.1% to 4.9%)

Code Ref: CBC 1133B.7.1.3 and ADA/ABA 403.3

As Built Meas: 145 Quantity: LF

Description: Cross slope exceeds 2.0% (4.1% to 4.9%)

Bar. Severity: 2 Recommended Cost Estimate: \$18,125.00 Status:

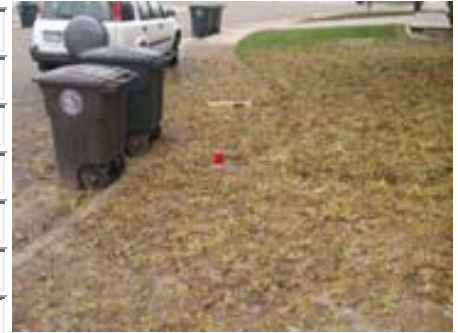
Field Date:	12/10/2010	Report Date:	12/10/2010	Barrier #:	3351
Location:	Cedar Garden Ct - South				
X Coordinate:	-121.29838				
Y Coordinate:	38.68376				
Barrier Area:	Sidewalks				
Barrier Type:	Cross Slope - Existing (3.1% to 4.0%)				
Code Ref:	CBC 1133B.7.1.3 and ADA/ABA 403.3

As Built Meas:	78	Quantity:	LF	
Description:	Cross slope exceeds 2.0% (3.1% to 4.0%)			
As Built Desc:	3.9% cross slope			
Solution:	Demolish existing and construct new route			
Bar. Severity:	3 Hinderance	Cost Estimate:	\$9,750.00	Status:
Implementation Priority:	4	Facility Function:		
Implementation Phase:		Implementation Date:		
Official Responsible:

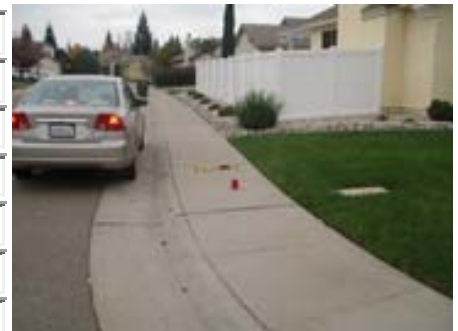
Field Date:	12/10/2010	Report Date:	12/10/2010	Barrier #:	3352
Location:	Cedar Ranch Dr - West				
X Coordinate:	-121.29809				
Y Coordinate:	38.68358				
Barrier Area:	Sidewalks				
Barrier Type:	Cross Slope - Existing (3.1% to 4.0%)				
Code Ref:	CBC 1133B.7.1.3 and ADA/ABA 403.3

As Built Meas:	212	Quantity:	LF	
Description:	Cross slope exceeds 2.0% (3.1% to 4.0%)			
As Built Desc:	3.4% cross slope			
Solution:	Demolish existing and construct new route			
Bar. Severity:	3 Hinderance	Cost Estimate:	\$26,500.00	Status:
Implementation Priority:	4	Facility Function:		
Implementation Phase:		Implementation Date:		
Official Responsible:

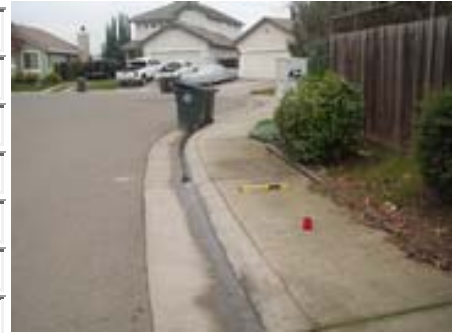
Field Date:	12/10/2010	Report Date:	12/10/2010	Barrier #:	3353
Location:	Cedar Ranch Dr - South				
X Coordinate:	-121.29847				
Y Coordinate:	38.68291				
Barrier Area:	Sidewalks				
Barrier Type:	Cross Slope - Existing (4.1% to 4.9%)				
Code Ref:	CBC 1133B.7.1.3 and ADA/ABA 403.3

As Built Meas:	82	Quantity:	LF	
Description:	Cross slope exceeds 2.0% (4.1% to 4.9%)			
As Built Desc:	4.1% cross slope			
Solution:	Demolish existing and construct new route			
Bar. Severity:	2 Recommended	Cost Estimate:	\$10,250.00	Status:
Implementation Priority:	4	Facility Function:		
Implementation Phase:		Implementation Date:		
Official Responsible:

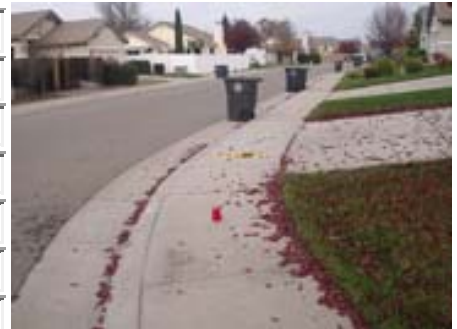
Field Date:	12/10/2010	Report Date:	12/10/2010	Barrier #:	3354
Location:	Cedar Ranch Dr - East				
X Coordinate:	-121.29824				
Y Coordinate:	38.68304				
Barrier Area:	Sidewalks				
Barrier Type:	Cross Slope - Existing (3.1% to 4.0%)				
Code Ref:	CBC 1133B.7.1.3 and ADA/ABA 403.3

As Built Meas:	262	Quantity:	LF	
Description:	Cross slope exceeds 2.0% (3.1% to 4.0%)			
As Built Desc:	3.5% cross slope			
Solution:	Demolish existing and construct new route			
Bar. Severity:	3 Hinderance	Cost Estimate:	\$32,750.00	Status:
Implementation Priority:	4	Facility Function:		
Implementation Phase:		Implementation Date:		
Official Responsible:

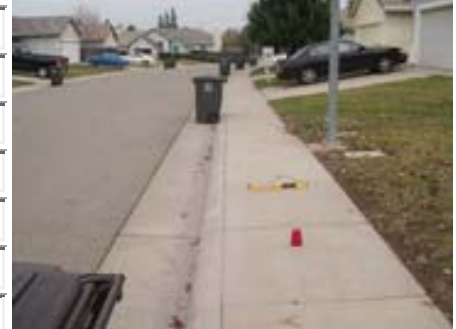
Field Date:	12/10/2010	Report Date:	12/10/2010	Barrier #:	3355
Location:	Cedar Ranch Dr - East				
X Coordinate:	-121.29719				
Y Coordinate:	38.68459				
Barrier Area:	Sidewalks				
Barrier Type:	Cross Slope - Existing (4.1% to 4.9%)				
Code Ref:	CBC 1133B.7.1.3 and ADA/ABA 403.3

As Built Meas:	67	Quantity:	LF	
Description:	Cross slope exceeds 2.0% (4.1% to 4.9%)			
As Built Desc:	4.1% cross slope			
Solution:	Demolish existing and construct new route			
Bar. Severity:	2 Recommended	Cost Estimate:	\$8,375.00	Status:
Implementation Priority:	4	Facility Function:		
Implementation Phase:		Implementation Date:		
Official Responsible:

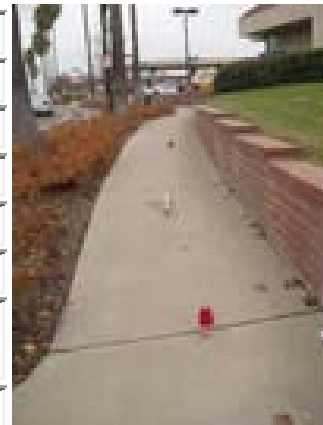
Field Date:	12/10/2010	Report Date:	12/10/2010	Barrier #:	3356
Location:	Fountain Square Dr - East				
X Coordinate:	-121.29815				
Y Coordinate:	38.6785				
Barrier Area:	Sidewalks				
Barrier Type:	Running Slope (Existing)				
Code Ref:	CBC 1133B.7.3 and ADA/ABA 403.3

As Built Meas:	20	Quantity:	LF	
Description:	Running slope exceeds 5.0%			
As Built Desc:	6.9% running slope			
Solution:	No remediation where sidewalk sloped as roadway			
Bar. Severity:	5 Technically Infeasible	Cost Estimate:	\$0.00	Status:
Implementation Priority:	4	Facility Function:		
Implementation Phase:		Implementation Date:		
Official Responsible:

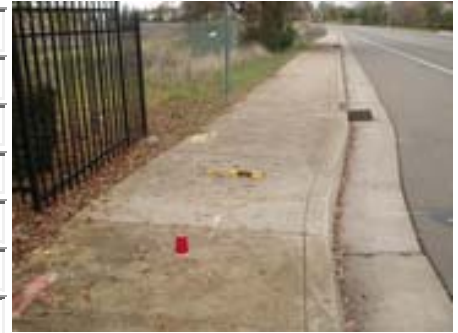
Field Date:	12/10/2010	Report Date:	12/10/2010	Barrier #:	3357
Location:	Stock Ranch Rd - South				
X Coordinate:	-121.29502				
Y Coordinate:	38.68257				
Barrier Area:	Sidewalks				
Barrier Type:	Cross Slope - Existing (3.1% to 4.0%)				
Code Ref:	CBC 1133B.7.1.3 and ADA/ABA 403.3

As Built Meas:	80	Quantity:	LF	
Description:	Cross slope exceeds 2.0% (3.1% to 4.0%)			
As Built Desc:	3.1% cross slope			
Solution:	Demolish existing and construct new route			
Bar. Severity:	3 Hindrance	Cost Estimate:	\$10,000.00	Status:
Implementation Priority:	4	Facility Function:		
Implementation Phase:		Implementation Date:		
Official Responsible:

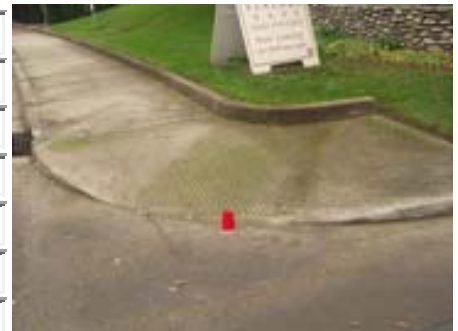
Field Date:	12/10/2010	Report Date:	12/10/2010	Barrier #:	3358A
Location:	Stock Ranch Rd and Vintage Oaks Entrance - Corner C				
X Coordinate:	-121.29386				
Y Coordinate:	38.68183				
Barrier Area:	Curb Ramps				
Barrier Type:	12" Grooves - Existing (3.1% to 4.0%)				
Code Ref:	CBC 1127B.5.6

As Built Meas:	1	Quantity:	EACH	
Description:	12" grooves at top of curb ramp are not level (3.1% to 4.0%)			
As Built Desc:	3.5% at 12" grooves			
Solution:	Demolish existing and construct new curb ramp			
Bar. Severity:	3 Hindrance	Cost Estimate:	\$2,500.00	Status:
Implementation Priority:	4	Facility Function:		
Implementation Phase:		Implementation Date:		
Official Responsible:

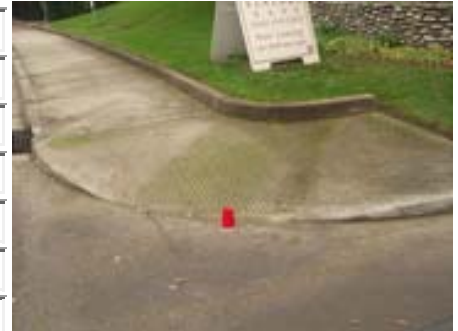
Field Date:	12/10/2010	Report Date:	12/10/2010	Barrier #:	3358B
Location:	Stock Ranch Rd and Vintage Oaks Entrance - Corner C				
X Coordinate:	-121.29386				
Y Coordinate:	38.68183				
Barrier Area:	Curb Ramps				
Barrier Type:	Perpendicular Ramp Landing - New Construction				
Code Ref:	CBC 1127B.5.4 and ADA/ABA 406.4

As Built Meas:	1	Quantity:	EACH		
Description:	Curb ramp top landing not min. 48" deep				
As Built Desc:	No top landing provided				
Solution:	Demolish existing and construct new transition				
Bar. Severity:	1 Necessary	Cost Estimate:	\$0.00	Status:	
Implementation Priority:	4	Facility Function:			
Implementation Phase:		Implementation Date:			
Official Responsible:

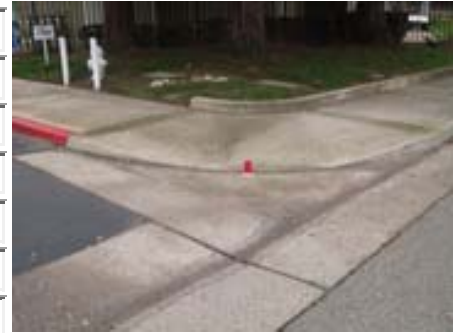
Field Date:	12/10/2010	Report Date:	12/10/2010	Barrier #:	3359A
Location:	Stock Ranch Rd and Vintage Oaks Entrance - Corner D				
X Coordinate:	-121.29408				
Y Coordinate:	38.68189				
Barrier Area:	Curb Ramps				
Barrier Type:	12" Grooves - Existing (4.1% to 4.9%)				
Code Ref:	CBC 1127B.5.6

As Built Meas:	1	Quantity:	EACH		
Description:	12" grooves at top of curb ramp are not level (4.1% to 4.9%)				
As Built Desc:	4.7% at 12" grooves				
Solution:	Demolish existing and construct new curb ramp				
Bar. Severity:	2 Recommended	Cost Estimate:	\$2,500.00	Status:	
Implementation Priority:	4	Facility Function:			
Implementation Phase:		Implementation Date:			
Official Responsible:

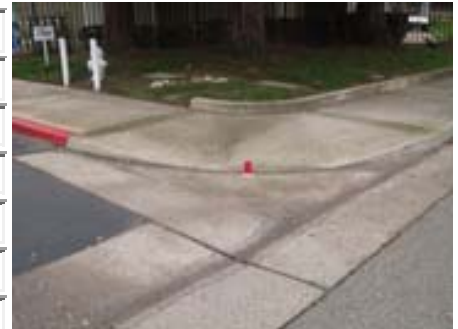
Field Date:	12/10/2010	Report Date:	12/10/2010	Barrier #:	3359B
Location:	Stock Ranch Rd and Vintage Oaks Entrance - Corner D				
X Coordinate:	-121.29408				
Y Coordinate:	38.68189				
Barrier Area:	Curb Ramps				
Barrier Type:	Flares - Existing (11.1% or more)				
Code Ref:	CBC 1127B.5.3 and ADA/ABA 406.3

As Built Meas:	1	Quantity:	EACH		
Description:	Ramp flare slope exceeds 10.0% (11.1% or more)				
As Built Desc:	13.6% flare slope				
Solution:	Demolish existing and construct new curb ramp				
Bar. Severity:	1 Necessary	Cost Estimate:	\$0.00	Status:	
Implementation Priority:	4	Facility Function:			
Implementation Phase:		Implementation Date:			
Official Responsible:

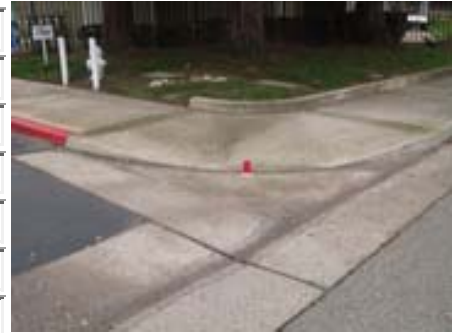
Field Date:	12/10/2010	Report Date:	12/10/2010	Barrier #:	3359C
Location:	Stock Ranch Rd and Vintage Oaks Entrance - Corner D				
X Coordinate:	-121.29408				
Y Coordinate:	38.68189				
Barrier Area:	Curb Ramps				
Barrier Type:	Running Slope - Existing (9.5% or more)				
Code Ref:	CBC 1127B.5.3 and ADA/ABA 406.1

As Built Meas:	1	Quantity:	EACH		
Description:	Ramp run cross slope exceeds 2.0% (9.5% or more)				
As Built Desc:	9.6% running slope				
Solution:	Demolish existing and construct new curb ramp				
Bar. Severity:	1 Necessary	Cost Estimate:	\$0.00	Status:	
Implementation Priority:	4	Facility Function:			
Implementation Phase:		Implementation Date:			
Official Responsible:

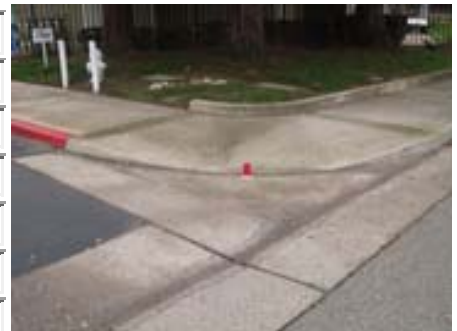
Field Date:	12/10/2010	Report Date:	12/10/2010	Barrier #:	3359D
Location:	Stock Ranch Rd and Vintage Oaks Entrance - Corner D				
X Coordinate:	-121.29408				
Y Coordinate:	38.68189				
Barrier Area:	Curb Ramps				
Barrier Type:	Perpendicular Ramp Landing - New Construction				
Code Ref:	CBC 1127B.5.4 and ADA/ABA 406.4

As Built Meas:	1	Quantity:	EACH		
Description:	Curb ramp top landing not min. 48" deep				
As Built Desc:	No top landing provided				
Solution:	Demolish existing and construct new transition				
Bar. Severity:	1 Necessary	Cost Estimate:	\$0.00	Status:	
Implementation Priority:	4	Facility Function:			
Implementation Phase:		Implementation Date:			
Official Responsible:

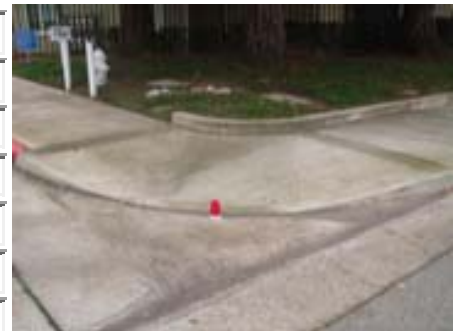
Field Date:	12/10/2010	Report Date:	12/10/2010	Barrier #:	3360A
Location:	Stock Ranch Rd and Vintage Oaks Entrance - Corner C				
X Coordinate:	-121.29301				
Y Coordinate:	38.68182				
Barrier Area:	Curb Ramps				
Barrier Type:	Running Slope - Existing (9.0% to 9.4%)				
Code Ref:	CBC 1127B.5.3 and ADA/ABA 406.1

As Built Meas:	1	Quantity:	EACH	
Description:	Ramp run cross slope exceeds 2.0% (9.0% to 9.4%)			
As Built Desc:	9.1% running slope			
Solution:	Demolish existing and construct new curb ramp			
Bar. Severity:	2 Recommended	Cost Estimate:	\$2,500.00	Status:
Implementation Priority:	4	Facility Function:		
Implementation Phase:		Implementation Date:		
Official Responsible:

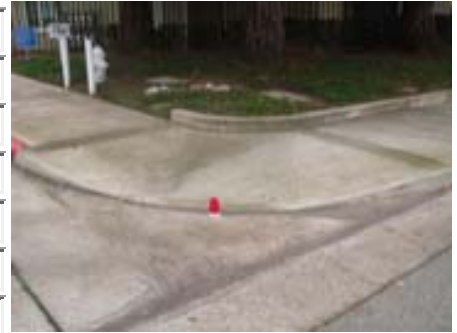
Field Date:	12/10/2010	Report Date:	12/10/2010	Barrier #:	3360B
Location:	Stock Ranch Rd and Vintage Oaks Entrance - Corner C				
X Coordinate:	-121.29301				
Y Coordinate:	38.68182				
Barrier Area:	Curb Ramps				
Barrier Type:	Perpendicular Ramp Landing - New Construction				
Code Ref:	CBC 1127B.5.4 and ADA/ABA 406.4

As Built Meas:	1	Quantity:	EACH		
Description:	Curb ramp top landing not min. 48" deep				
As Built Desc:	No top landing provided				
Solution:	Demolish existing and construct new transition				
Bar. Severity:	1 Necessary	Cost Estimate:	\$0.00	Status:	
Implementation Priority:	4	Facility Function:			
Implementation Phase:		Implementation Date:			
Official Responsible:

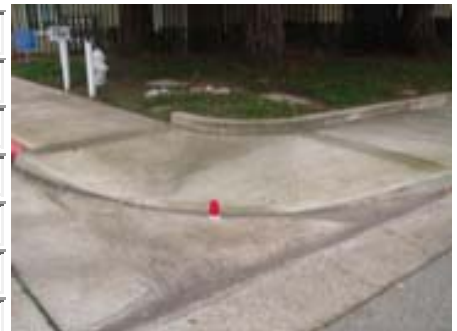
Field Date:	12/10/2010	Report Date:	12/10/2010	Barrier #:	3360C
Location:	Stock Ranch Rd and Vintage Oaks Entrance - Corner C				
X Coordinate:	-121.29301				
Y Coordinate:	38.68182				
Barrier Area:	Curb Ramps				
Barrier Type:	Detectable Warnings - Truncated Domes				
Code Ref:	CBC 1127B.5.7 and ADA/ABA 705.1.3

As Built Meas:	1	Quantity:	EACH		
Description:	No truncated domes provided at curb ramp				
As Built Desc:	No detectable warnings at curb ramp				
Solution:	Provide compliant truncated domes				
Bar. Severity:	2 Recommended	Cost Estimate:	\$0.00	Status:	
Implementation Priority:	4	Facility Function:			
Implementation Phase:		Implementation Date:			
Official Responsible:

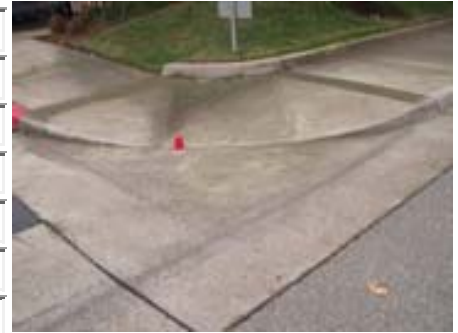
Field Date:	12/10/2010	Report Date:	12/10/2010	Barrier #:	3361A
Location:	Stock Ranch Rd and Vintage Oaks Entrance - Corner D				
X Coordinate:	-121.29318				
Y Coordinate:	38.6818				
Barrier Area:	Curb Ramps				
Barrier Type:	Perpendicular Ramp Landing - New Construction				
Code Ref:	CBC 1127B.5.4 and ADA/ABA 406.4

As Built Meas:	1	Quantity:	EACH		
Description:	Curb ramp top landing not min. 48" deep				
As Built Desc:	No top landing provided				
Solution:	Demolish existing and construct new transition				
Bar. Severity:	1 Necessary	Cost Estimate:	\$250.00	Status:	
Implementation Priority:	4	Facility Function:			
Implementation Phase:		Implementation Date:			
Official Responsible:

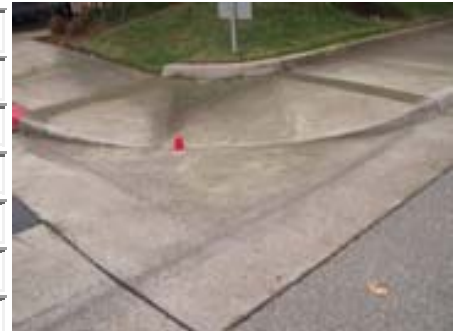
Field Date:	12/10/2010	Report Date:	12/10/2010	Barrier #:	3361B
Location:	Stock Ranch Rd and Vintage Oaks Entrance - Corner D				
X Coordinate:	-121.29318				
Y Coordinate:	38.6818				
Barrier Area:	Curb Ramps				
Barrier Type:	Detectable Warnings - Truncated Domes				
Code Ref:	CBC 1127B.5.7 and ADA/ABA 705.1.3

As Built Meas:	1	Quantity:	EACH		
Description:	No truncated domes provided at curb ramp				
As Built Desc:	No detectable warnings at curb ramp				
Solution:	Provide compliant truncated domes				
Bar. Severity:	2 Recommended	Cost Estimate:	\$1,400.00	Status:	
Implementation Priority:	4	Facility Function:			
Implementation Phase:		Implementation Date:			
Official Responsible:

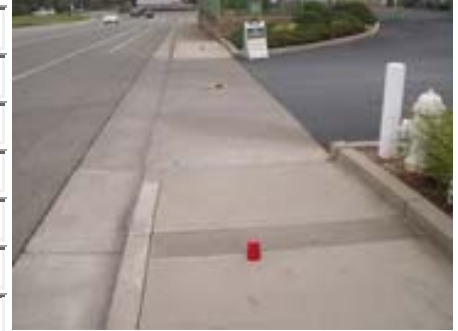
Field Date:	12/10/2010	Report Date:	12/10/2010	Barrier #:	3362
Location:	Stock Ranch Rd - South				
X Coordinate:	-121.29161				
Y Coordinate:	38.68182				
Barrier Area:	Sidewalks				
Barrier Type:	Driveway - Existing (3.1% to 4.0%)				
Code Ref:	CBC 1133B.7.1.3 and ADA/ABA 403.3

As Built Meas:	35	Quantity:	LF	
Description:	Driveway cross slope exceeds 2.0% (3.1% to 4.0%)			
As Built Desc:	3.7% cross slope, 9.1% running slope			
Solution:	Provide min. 48" wide level walkway through driveway			
Bar. Severity:	1 Necessary	Cost Estimate:	\$4,375.00	Status:
Implementation Priority:	4	Facility Function:		
Implementation Phase:		Implementation Date:		
Official Responsible:

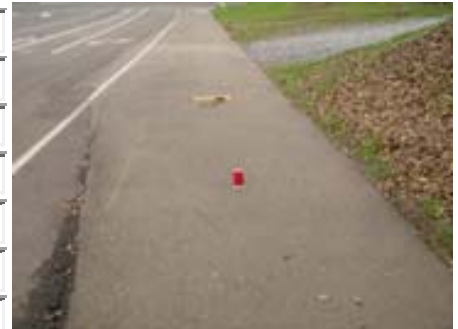
Field Date:	12/10/2010	Report Date:	12/10/2010	Barrier #:	3363
Location:	Stock Ranch Rd - South				
X Coordinate:	-121.29116				
Y Coordinate:	38.6818				
Barrier Area:	Sidewalks				
Barrier Type:	Cross Slope - Existing (3.1% to 4.0%)				
Code Ref:	CBC 1133B.7.1.3 and ADA/ABA 403.3

As Built Meas:	174	Quantity:	LF	
Description:	Cross slope exceeds 2.0% (3.1% to 4.0%)			
As Built Desc:	3.9% cross slope			
Solution:	Demolish existing and construct new route			
Bar. Severity:	3 Hinderance	Cost Estimate:	\$21,750.00	Status:
Implementation Priority:	4	Facility Function:		
Implementation Phase:		Implementation Date:		
Official Responsible:

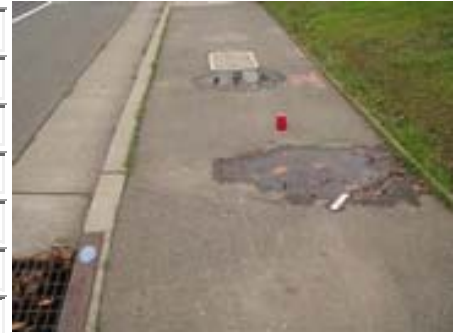
Field Date:	12/10/2010	Report Date:	12/10/2010	Barrier #:	3364
Location:	Sylvan Rd - West				
X Coordinate:	-121.29042				
Y Coordinate:	38.68167				
Barrier Area:	Sidewalks				
Barrier Type:	Surface Condition - Damaged				
Code Ref:	CBC 1133B.7.1 and ADA/ABA 302.1

As Built Meas:	6	Quantity:	LF	
Description:	Surface is not firm and stable (cracked, broken or loose soil, etc.)			
As Built Desc:	Cracked concrete			
Solution:	Repair surface to make firm and stable			
Bar. Severity:	1 Necessary	Cost Estimate:	\$750.00	Status:
Implementation Priority:	4	Facility Function:		
Implementation Phase:		Implementation Date:		
Official Responsible:

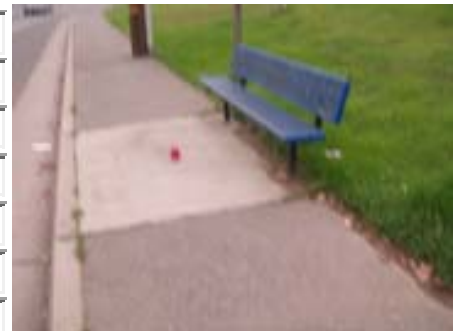
Field Date:	12/10/2010	Report Date:	12/10/2010	Barrier #:	3365A
Location:	Sylvan Rd - West				
X Coordinate:	-121.29043				
Y Coordinate:	38.68149				
Barrier Area:	Bus Stops and Shelters				
Barrier Type:	Bench Back Support				
Code Ref:	ADAAG 4.37.4 and ADA/ABA 903.4

As Built Meas:	1	Quantity:	EACH	
Description:	Bench has no back support of at least 18" high			
As Built Desc:	15-1/2" back support height			
Solution:	Provide min. 1 accessible bench at bench stop or shelter			
Bar. Severity:	3 Hindrance	Cost Estimate:	\$775.00	Status:
Implementation Priority:	4	Facility Function:		
Implementation Phase:		Implementation Date:		
Official Responsible:

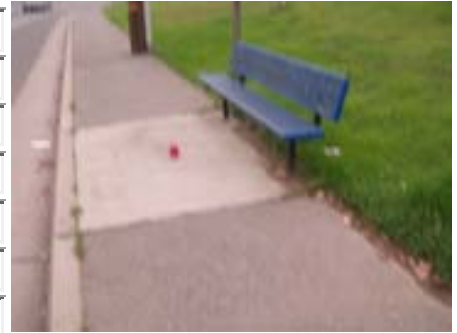
Field Date:	12/10/2010	Report Date:	12/10/2010	Barrier #:	3365B
Location:	Sylvan Rd - West				
X Coordinate:	-121.29043				
Y Coordinate:	38.68149				
Barrier Area:	Bus Stops and Shelters				
Barrier Type:	Bench Seat Depth				
Code Ref:	ADAAG 4.37.1 and ADA/ABA 903.4

As Built Meas:	1	Quantity:	EACH	
Description:	Bench seat depth not 20" - 24" deep			
As Built Desc:	12-1/2" bench seat depth			
Solution:	Provide min. 1 accessible bench at bench stop			
Bar. Severity:	3 Hindrance	Cost Estimate:	\$0.00	Status:
Implementation Priority:	4	Facility Function:		
Implementation Phase:		Implementation Date:		
Official Responsible:

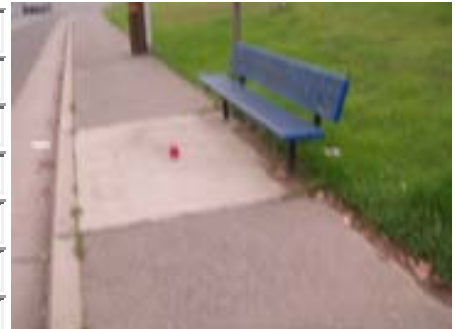
Field Date:	12/10/2010	Report Date:	12/10/2010	Barrier #:	3365C
Location:	Sylvan Rd - West				
X Coordinate:	-121.29043				
Y Coordinate:	38.68149				
Barrier Area:	Bus Stops and Shelters				
Barrier Type:	Bench Seat Height				
Code Ref:	ADAAG 4.37.3* and ADA/ABA 903.4

As Built Meas:	1	Quantity:	EACH	
Description:	Bench seat height not between 17" - 19"			
As Built Desc:	16-1/2" bench seat height			
Solution:	Provide new compliant bench or remount at compliant height where possible			
Bar. Severity:	3 Hindrance	Cost Estimate:	\$0.00	Status:
Implementation Priority:	4	Facility Function:		
Implementation Phase:		Implementation Date:		
Official Responsible:

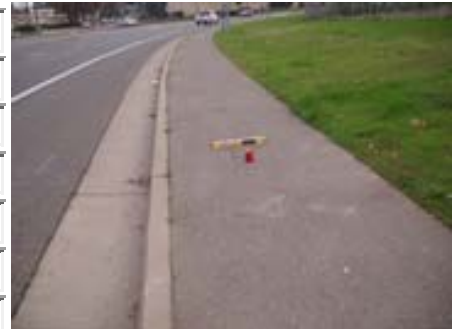
Field Date:	12/10/2010	Report Date:	12/10/2010	Barrier #:	3366
Location:	Sylvan Rd - West				
X Coordinate:	-121.29044				
Y Coordinate:	38.68138				
Barrier Area:	Sidewalks				
Barrier Type:	Cross Slope - Existing (3.1% to 4.0%)				
Code Ref:	CBC 1133B.7.1.3 and ADA/ABA 403.3

As Built Meas:	326	Quantity:	LF		
Description:	Cross slope exceeds 2.0% (3.1% to 4.0%)				
As Built Desc:	3.5% cross slope				
Solution:	Demolish existing and construct new route				
Bar. Severity:	3 Hinderance	Cost Estimate:	\$40,750.00	Status:	
Implementation Priority:	4	Facility Function:			
Implementation Phase:		Implementation Date:			
Official Responsible:

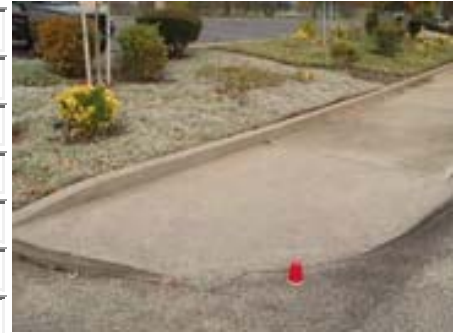
As Built Meas: 1 Quantity: EACH  
 Description: No compliant curb cut at corner (intersection)  
 As Built Desc: 8.4% running slope at depressed area  
 Solution: Demolish existing and construct curb cut  
 Bar. Severity: 1 Necessary Cost Estimate: \$2,500.00 Status:  
 Implementation Priority: 4 Facility Function:  
 Implementation Phase: Implementation Date:  
 Official Responsible:

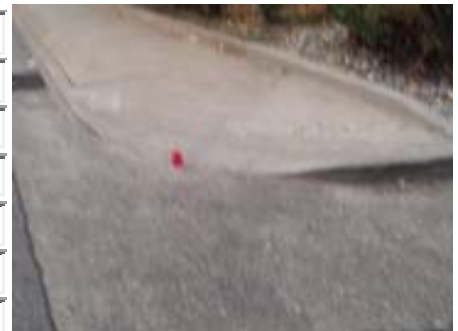
As Built Meas: 1 Quantity: EACH  
 Description: No compliant curb cut at corner (intersection)  
 As Built Desc: 14.7% running slope at depressed area  
 Solution: Demolish existing and construct curb cut  
 Bar. Severity: 1 Necessary Cost Estimate: \$2,500.00 Status:  
 Implementation Priority: 4 Facility Function:  
 Implementation Phase: Implementation Date:  
 Official Responsible:

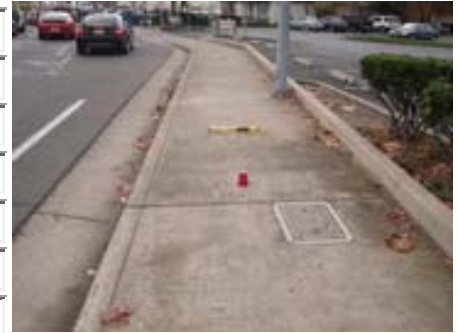
Field Date:	12/10/2010	Report Date:	12/10/2010	Barrier #:	3369
Location:	San Juan Ave - West				
X Coordinate:	-121.29229				
Y Coordinate:	38.67934				
Barrier Area:	Sidewalks				
Barrier Type:	Cross Slope - Existing (3.1% to 4.0%)				
Code Ref:	CBC 1133B.7.1.3 and ADA/ABA 403.3

As Built Meas:	40	Quantity:	LF
Description:	Cross slope exceeds 2.0% (3.1% to 4.0%)		
As Built Desc:	4.0% cross slope		
Solution:	Demolish existing and construct new route		
Bar. Severity:	3 Hinderance	Cost Estimate:	\$5,000.00
Implementation Priority:	4	Facility Function:	
Implementation Phase:		Implementation Date:	
Official Responsible:

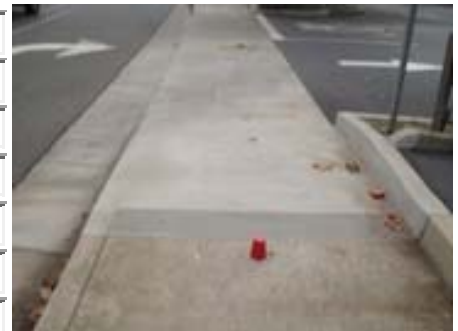
Field Date:	12/10/2010	Report Date:	12/10/2010	Barrier #:	3370
Location:	San Juan Ave - West				
X Coordinate:	-121.2926				
Y Coordinate:	38.67887				
Barrier Area:	Sidewalks				
Barrier Type:	Driveway - Existing (3.1% to 4.0%)				
Code Ref:	CBC 1133B.7.1.3 and ADA/ABA 403.3

As Built Meas:	40	Quantity:	LF
Description:	Driveway cross slope exceeds 2.0% (3.1% to 4.0%)		
As Built Desc:	4.0% cross slope		
Solution:	Provide min. 48" wide level walkway through driveway		
Bar. Severity:	2 Recommended	Cost Estimate:	\$5,000.00
Implementation Priority:	4	Facility Function:	
Implementation Phase:		Implementation Date:	
Official Responsible:

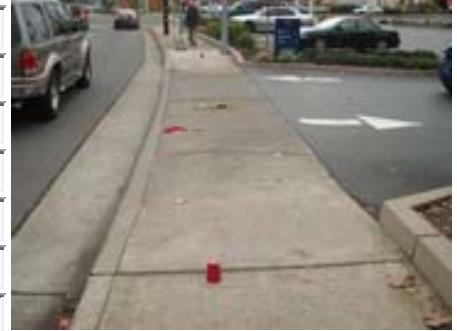
Field Date:	12/10/2010	Report Date:	12/10/2010	Barrier #:	3371
Location:	San Juan Ave - West				
X Coordinate:	-121.29262				
Y Coordinate:	38.67882				
Barrier Area:	Sidewalks				
Barrier Type:	Driveway - Existing (4.1% to 4.9%)				
Code Ref:	CBC 1133B.7.1.3 and ADA/ABA 403.3

As Built Meas:	40	Quantity:	LF		
Description:	Driveway cross slope exceeds 2.0% (4.1% to 4.9%)				
As Built Desc:	4.2% cross slope, 10.6% running slope				
Solution:	Provide min. 48" wide level walkway through driveway				
Bar. Severity:	1 Necessary	Cost Estimate:	\$5,000.00	Status:	
Implementation Priority:	4	Facility Function:			
Implementation Phase:		Implementation Date:			
Official Responsible:

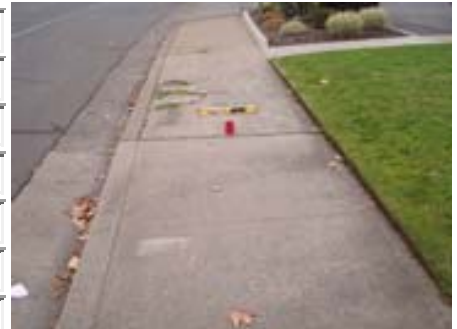
Field Date:	12/10/2010	Report Date:	12/10/2010	Barrier #:	3372A
Location:	Sylvan Rd - East				
X Coordinate:	-121.2923				
Y Coordinate:	38.6786				
Barrier Area:	Sidewalks				
Barrier Type:	Cross Slope - Existing (4.1% to 4.9%)				
Code Ref:	CBC 1133B.7.1.3 and ADA/ABA 403.3

As Built Meas:	50	Quantity:	LF		
Description:	Cross slope exceeds 2.0% (4.1% to 4.9%)				
As Built Desc:	4.5% cross slope				
Solution:	Demolish existing and construct new route				
Bar. Severity:	2 Recommended	Cost Estimate:	\$6,250.00	Status:	
Implementation Priority:	4	Facility Function:			
Implementation Phase:		Implementation Date:			
Official Responsible:

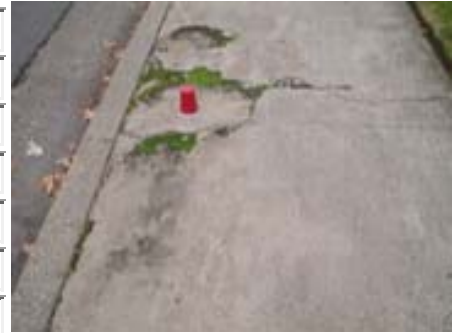
Field Date:	12/10/2010	Report Date:	12/10/2010	Barrier #:	3372B
Location:	Sylvan Rd - East				
X Coordinate:	-121.2923				
Y Coordinate:	38.6786				
Barrier Area:	Sidewalks				
Barrier Type:	Surface Condition - Damaged				
Code Ref:	CBC 1133B.7.1 and ADA/ABA 302.1

As Built Meas:	4	Quantity:	LF	
Description:	Surface is not firm and stable (cracked, broken or loose soil, etc.)			
As Built Desc:	Cracked concrete			
Solution:	Repair surface to make firm and stable			
Bar. Severity:	1 Necessary	Cost Estimate:	\$500.00	Status:
Implementation Priority:	4	Facility Function:		
Implementation Phase:		Implementation Date:		
Official Responsible:

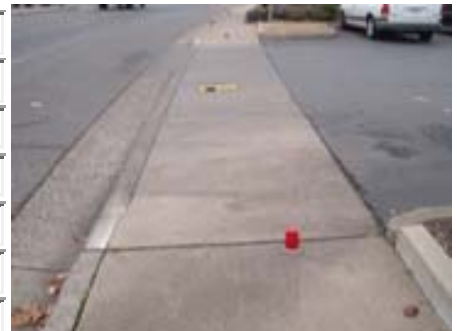
Field Date:	12/10/2010	Report Date:	12/10/2010	Barrier #:	3373
Location:	Sylvan Rd - East				
X Coordinate:	-121.29229				
Y Coordinate:	38.6787				
Barrier Area:	Sidewalks				
Barrier Type:	Driveway - Existing (5.0% or more)				
Code Ref:	CBC 1133B.7.1.3 and ADA/ABA 403.3

As Built Meas:	35	Quantity:	LF	
Description:	Driveway cross slope exceeds 2.0% (5.0% or more)			
As Built Desc:	10.2% cross slope			
Solution:	Provide min. 48" wide level walkway through driveway			
Bar. Severity:	4 Low Severity	Cost Estimate:	\$4,375.00	Status:
Implementation Priority:	4	Facility Function:		
Implementation Phase:		Implementation Date:		
Official Responsible:

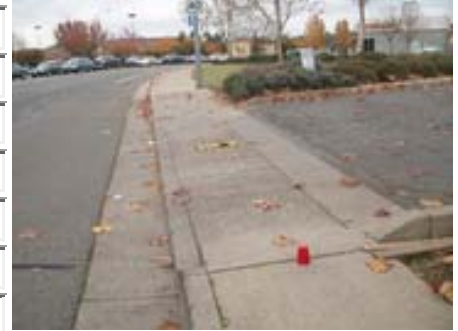
Field Date:	12/10/2010	Report Date:	12/10/2010	Barrier #:	3374
Location:	San Juan Ave - East				
X Coordinate:	-121.2922				
Y Coordinate:	38.67884				
Barrier Area:	Sidewalks				
Barrier Type:	Driveway - Existing (3.1% to 4.0%)				
Code Ref:	CBC 1133B.7.1.3 and ADA/ABA 403.3

As Built Meas:	35	Quantity:	LF	
Description:	Driveway cross slope exceeds 2.0% (3.1% to 4.0%)			
As Built Desc:	3.8% cross slope, 16.4% running slope			
Solution:	Provide min. 48" wide level walkway through driveway			
Bar. Severity:	1 Necessary	Cost Estimate:	\$4,375.00	Status:
Implementation Priority:	4	Facility Function:		
Implementation Phase:		Implementation Date:		
Official Responsible:

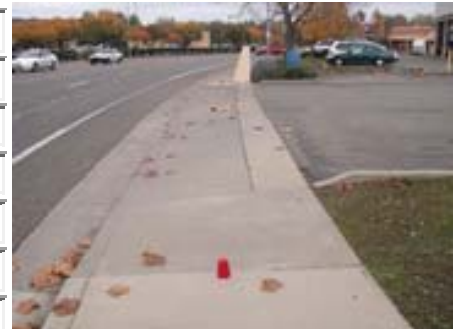
Field Date:	12/10/2010	Report Date:	12/10/2010	Barrier #:	3375
Location:	San Juan Ave - East				
X Coordinate:	-121.29209				
Y Coordinate:	38.6793				
Barrier Area:	Sidewalks				
Barrier Type:	Driveway - Existing (4.1% to 4.9%)				
Code Ref:	CBC 1133B.7.1.3 and ADA/ABA 403.3

As Built Meas:	55	Quantity:	LF	
Description:	Driveway cross slope exceeds 2.0% (4.1% to 4.9%)			
As Built Desc:	4.8% cross slope, 15.8% running slope			
Solution:	Provide min. 48" wide level walkway through driveway			
Bar. Severity:	1 Necessary	Cost Estimate:	\$6,875.00	Status:
Implementation Priority:	4	Facility Function:		
Implementation Phase:		Implementation Date:		
Official Responsible:

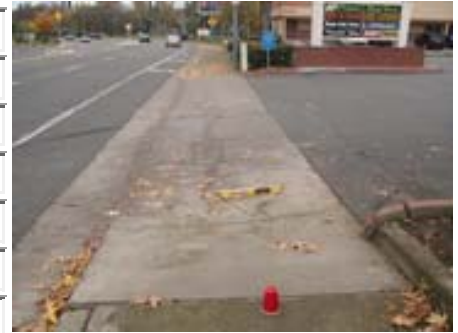
Field Date:	12/10/2010	Report Date:	12/10/2010	Barrier #:	3376
Location:	San Juan Ave - East				
X Coordinate:	-121.29152				
Y Coordinate:	38.67974				
Barrier Area:	Sidewalks				
Barrier Type:	Driveway - Existing (5.0% or more)				
Code Ref:	CBC 1133B.7.1.3 and ADA/ABA 403.3

As Built Meas:	55	Quantity:	LF		
Description:	Driveway cross slope exceeds 2.0% (5.0% or more)				
As Built Desc:	9.0% cross slope, 12.6% running slope at cracked concrete				
Solution:	Provide min. 48" wide level walkway through driveway				
Bar. Severity:	1 Necessary	Cost Estimate:	\$6,875.00	Status:	
Implementation Priority:	4	Facility Function:			
Implementation Phase:		Implementation Date:			
Official Responsible:

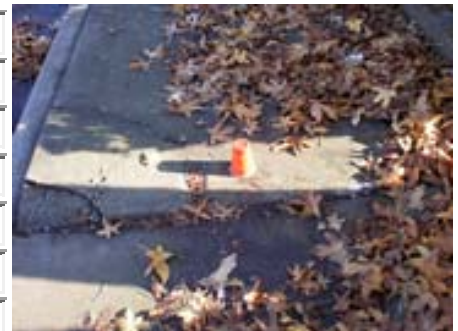
Field Date:	12/10/2010	Report Date:	12/10/2010	Barrier #:	3377
Location:	Sylvan Rd - West				
X Coordinate:	-121.29137				
Y Coordinate:	38.67984				
Barrier Area:	Sidewalks				
Barrier Type:	Abrupt Change in Level - > 1/2"				
Code Ref:	CBC 1133B.7.1 and ADA/ABA 303.3

As Built Meas:	4	Quantity:	LF		
Description:	Change in level greater than 1/2"				
As Built Desc:	1" lip in sidewalk surface				
Solution:	Grind or repair sidewalk to remove trip hazard				
Bar. Severity:	1 Necessary	Cost Estimate:	\$1,000.00	Status:	
Implementation Priority:	4	Facility Function:			
Implementation Phase:		Implementation Date:			
Official Responsible:

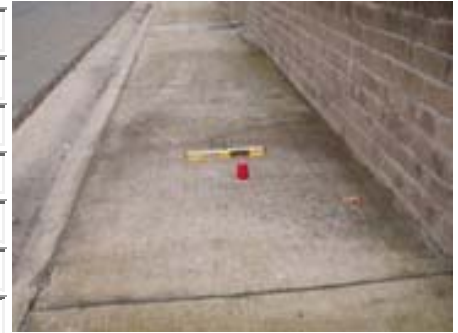
Field Date:	12/10/2010	Report Date:	12/10/2010	Barrier #:	3378
Location:	Sylvan Rd - West				
X Coordinate:	-121.29033				
Y Coordinate:	38.68034				
Barrier Area:	Sidewalks				
Barrier Type:	Cross Slope - Existing (5.0% or more)				
Code Ref:	CBC 1133B.7.1.3 and ADA/ABA 403.3

As Built Meas:	50	Quantity:	LF
Description:	Cross slope exceeds 2.0% (5.0% or more)		
As Built Desc:	5.7% cross slope		
Solution:	Demolish existing and construct new route		
Bar. Severity:	1 Necessary	Cost Estimate:	\$6,250.00
Implementation Priority:	4	Facility Function:	
Implementation Phase:		Implementation Date:	
Official Responsible:

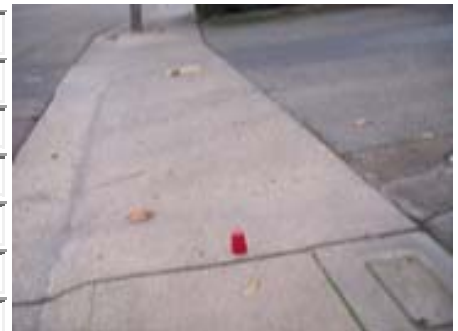
Field Date:	12/10/2010	Report Date:	12/10/2010	Barrier #:	3379
Location:	Sylvan Rd - West				
X Coordinate:	-121.29033				
Y Coordinate:	38.68012				
Barrier Area:	Sidewalks				
Barrier Type:	Driveway - Existing (5.0% or more)				
Code Ref:	CBC 1133B.7.1.3 and ADA/ABA 403.3

As Built Meas:	35	Quantity:	LF
Description:	Driveway cross slope exceeds 2.0% (5.0% or more)		
As Built Desc:	6.7% cross slope		
Solution:	Provide min. 48" wide level walkway through driveway		
Bar. Severity:	4 Low Severity	Cost Estimate:	\$4,375.00
Implementation Priority:	4	Facility Function:	
Implementation Phase:		Implementation Date:	
Official Responsible:

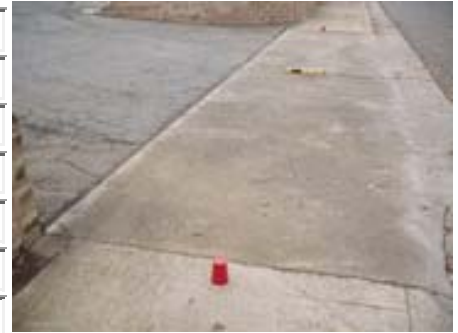
Field Date:	12/10/2010	Report Date:	12/10/2010	Barrier #:	3380
Location:	Sylvan Rd - West				
X Coordinate:	-121.29031				
Y Coordinate:	38.67998				
Barrier Area:	Sidewalks				
Barrier Type:	Cross Slope - Existing (4.1% to 4.9%)				
Code Ref:	CBC 1133B.7.1.3 and ADA/ABA 403.3

As Built Meas:	325	Quantity:	LF	
Description:	Cross slope exceeds 2.0% (4.1% to 4.9%)			
As Built Desc:	4.8% cross slope			
Solution:	Demolish existing and construct new route			
Bar. Severity:	2 Recommended	Cost Estimate:	\$40,625.00	Status:
Implementation Priority:	4	Facility Function:		
Implementation Phase:		Implementation Date:		
Official Responsible:

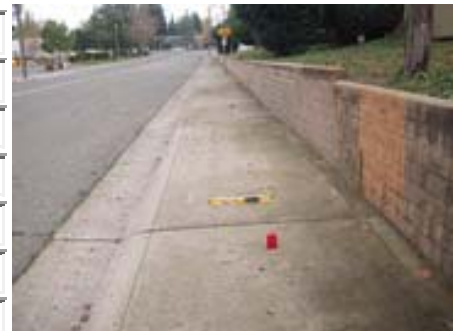
Field Date:	12/10/2010	Report Date:	12/10/2010	Barrier #:	3381
Location:	Sylvan Rd - West				
X Coordinate:	-121.29033				
Y Coordinate:	38.67895				
Barrier Area:	Sidewalks				
Barrier Type:	Driveway - Existing (5.0% or more)				
Code Ref:	CBC 1133B.7.1.3 and ADA/ABA 403.3

As Built Meas:	40	Quantity:	LF	
Description:	Driveway cross slope exceeds 2.0% (5.0% or more)			
As Built Desc:	8.0% cross slope, 12.8% running slope			
Solution:	Provide min. 48" wide level walkway through driveway			
Bar. Severity:	1 Necessary	Cost Estimate:	\$5,000.00	Status:
Implementation Priority:	4	Facility Function:		
Implementation Phase:		Implementation Date:		
Official Responsible:

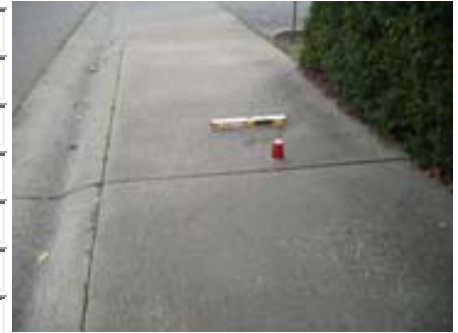
Field Date:	12/10/2010	Report Date:	12/10/2010	Barrier #:	3382
Location:	Sylvan Rd - West				
X Coordinate:	-121.29032				
Y Coordinate:	38.6789				
Barrier Area:	Sidewalks				
Barrier Type:	Cross Slope - Existing (3.1% to 4.0%)				
Code Ref:	CBC 1133B.7.1.3 and ADA/ABA 403.3

As Built Meas:	32	Quantity:	LF
Description:	Cross slope exceeds 2.0% (3.1% to 4.0%)		
As Built Desc:	3.2% cross slope		
Solution:	Demolish existing and construct new route		
Bar. Severity:	3 Hinderance	Cost Estimate:	\$4,000.00
Implementation Priority:	4	Facility Function:	
Implementation Phase:		Implementation Date:	
Official Responsible:

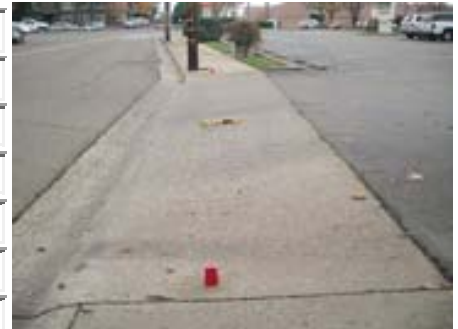
Field Date:	12/10/2010	Report Date:	12/10/2010	Barrier #:	3383
Location:	Sylvan Rd - West				
X Coordinate:	-121.29037				
Y Coordinate:	38.67876				
Barrier Area:	Sidewalks				
Barrier Type:	Driveway - Existing (5.0% or more)				
Code Ref:	CBC 1133B.7.1.3 and ADA/ABA 403.3

As Built Meas:	40	Quantity:	LF
Description:	Driveway cross slope exceeds 2.0% (5.0% or more)		
As Built Desc:	8.2% cross slope, 10.5% running slope		
Solution:	Provide min. 48" wide level walkway through driveway		
Bar. Severity:	1 Necessary	Cost Estimate:	\$5,000.00
Implementation Priority:	4	Facility Function:	
Implementation Phase:		Implementation Date:	
Official Responsible:

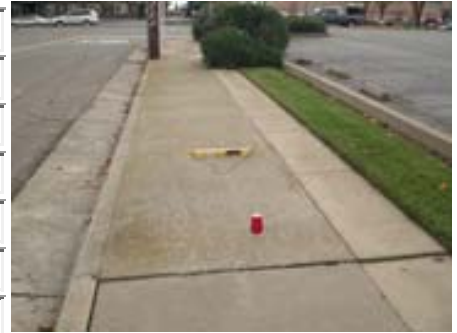
Field Date:	12/10/2010	Report Date:	12/10/2010	Barrier #:	3384
Location:	Sylvan Rd - West				
X Coordinate:	-121.29035				
Y Coordinate:	38.67868				
Barrier Area:	Sidewalks				
Barrier Type:	Cross Slope - Existing (4.1% to 4.9%)				
Code Ref:	CBC 1133B.7.1.3 and ADA/ABA 403.3

As Built Meas:	60	Quantity:	LF
Description:	Cross slope exceeds 2.0% (4.1% to 4.9%)		
As Built Desc:	4.1% cross slope		
Solution:	Demolish existing and construct new route		
Bar. Severity:	2 Recommended	Cost Estimate:	\$7,500.00
		Status:	
Implementation Priority:	4	Facility Function:	
Implementation Phase:		Implementation Date:	
Official Responsible:			
Notes:
