DRAFT ADA TRANSITION PLAN UPDATE
NEIGHBORHOOD AREA 9 SONA
SEPTEMBER 20, 2011

CITY OF CITRUS HEIGHTS

The Sunrise Oaks Neighborhood Association (SONA)

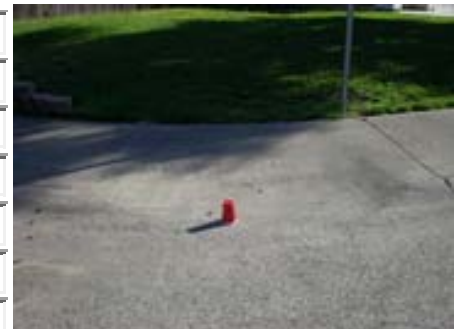
Field Date:	3/31/2011	Report Date:	3/31/2011	Barrier #:	6362
Location:	Menke Wy and Janquil Wy - Corner B				
X Coordinate:	-121.24849				
Y Coordinate:	38.70006				
Barrier Area:	Curb Ramps				
Barrier Type:	No Curb Ramp - Depressed Existing Curb				
Code Ref:	CBC 1127B.5.1 and ADA/ABA 402.2

As Built Meas:	1	Quantity:	EACH
Description:	No compliant curb cut at corner (intersection)		
As Built Desc:	10.1% running slope at depressed area		
Solution:	Demolish existing and construct curb cut		
Bar. Severity:	1 Necessary	Cost Estimate:	\$2,500.00
Implementation Priority:	4	Facility Function:	
Implementation Phase:		Implementation Date:	
Official Responsible:

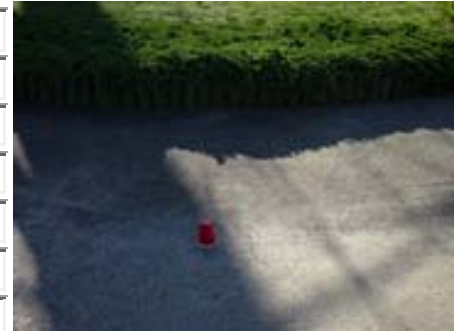
Barrier Type: No Curb Ramp - Depressed Existing Curb

Code Ref: CBC 1127B.5.1 and ADA/ABA 402.2

Description: No compliant curb cut at corner (intersection)

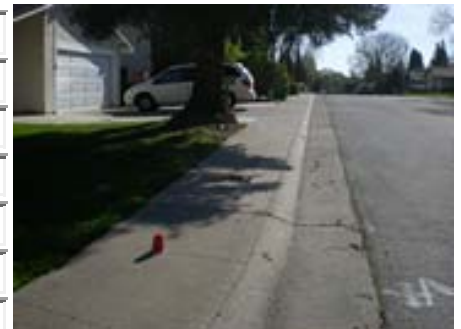
Barrier Type: Cross Slope - Existing (4.1% to 4.9%)

Code Ref: CBC 1133B.7.1.3 and ADA/ABA 403.3

Description: Cross slope exceeds 2.0% (4.1% to 4.9%)

Bar. Severity: 2 Recommended Cost Estimate: \$121,000.00 Status:

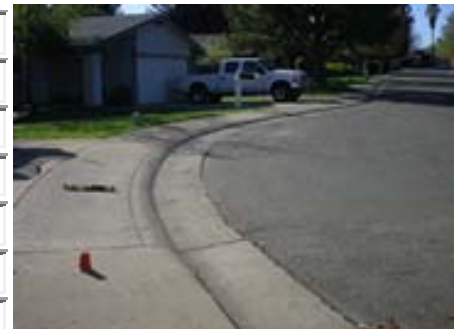
Field Date:	3/31/2011	Report Date:	3/31/2011	Barrier #:	6365A
Location:	Janquil Wy - East				
X Coordinate:	-121.24498				
Y Coordinate:	38.7				
Barrier Area:	Sidewalks				
Barrier Type:	Cross Slope - Existing (3.1% to 4.0%)				
Code Ref:	CBC 1133B.7.1.3 and ADA/ABA 403.3

As Built Meas:	528	Quantity:	LF
Description:	Cross slope exceeds 2.0% (3.1% to 4.0%)		
As Built Desc:	3.1% cross slope		
Solution:	Demolish existing and construct new route		
Bar. Severity:	3 Hindrance	Cost Estimate:	\$66,000.00
Implementation Priority:	4	Facility Function:	
Implementation Phase:		Implementation Date:	
Official Responsible:			
Notes:

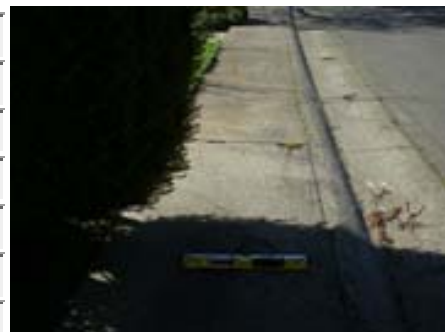
Field Date:	3/31/2011	Report Date:	3/31/2011	Barrier #:	6365B
Location:	Janquil Wy - East				
X Coordinate:	-121.24497				
Y Coordinate:	38.69957				
Barrier Area:	Sidewalks				
Barrier Type:	Clear Width - New Construction				
Code Ref:	CBC 1133B.7.1

As Built Meas:	1	Quantity:	LF
Description:	Pedestrian route is not min. 48" wide		
As Built Desc:	24" clear width due to foliage		
Solution:	Trim foliage to provide min. 48" clear width		
Bar. Severity:	1 Necessary	Cost Estimate:	\$125.00
Implementation Priority:	4	Facility Function:	
Implementation Phase:		Implementation Date:	
Official Responsible:			
Notes:

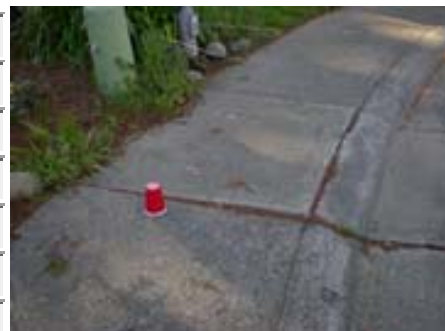
Field Date:	3/31/2011	Report Date:	3/31/2011	Barrier #:	6365C
Location:	Janquil Wy - East				
X Coordinate:	-121.24491				
Y Coordinate:	38.6988				
Barrier Area:	Sidewalks				
Barrier Type:	Abrupt Change in Level - > 1/2"				
Code Ref:	CBC 1133B.7.1 and ADA/ABA 303.3

As Built Meas:	4	Quantity:	LF
Description:	Change in level greater than 1/2"		
As Built Desc:	1/2" lip in sidewalk surface		
Solution:	Grind or repair sidewalk to remove trip hazard		
Bar. Severity:	1 Necessary	Cost Estimate:	\$1,000.00
Implementation Priority:	4	Facility Function:	
Implementation Phase:		Implementation Date:	
Official Responsible:			
Notes:

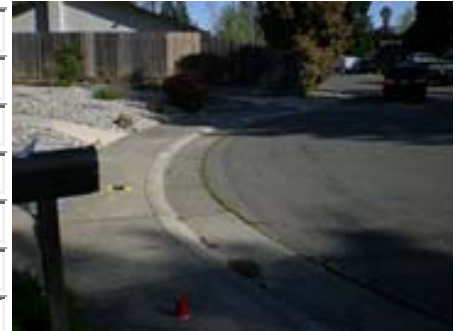
Field Date:	3/31/2011	Report Date:	3/31/2011	Barrier #:	6366A
Location:	Janquil Wy - West				
X Coordinate:	-121.24515				
Y Coordinate:	38.69869				
Barrier Area:	Sidewalks				
Barrier Type:	Cross Slope - Existing (3.1% to 4.0%)				
Code Ref:	CBC 1133B.7.1.3 and ADA/ABA 403.3

As Built Meas:	168	Quantity:	LF
Description:	Cross slope exceeds 2.0% (3.1% to 4.0%)		
As Built Desc:	3.2% cross slope		
Solution:	Demolish existing and construct new route		
Bar. Severity:	3 Hindrance	Cost Estimate:	\$21,000.00
Implementation Priority:	4	Facility Function:	
Implementation Phase:		Implementation Date:	
Official Responsible:

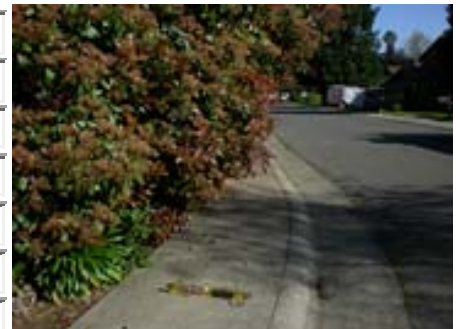
Field Date:	3/31/2011	Report Date:	3/31/2011	Barrier #:	6366B
Location:	Janquil Wy - West				
X Coordinate:	-121.24507				
Y Coordinate:	38.69889				
Barrier Area:	Sidewalks				
Barrier Type:	Protruding Hazard				
Code Ref:	CBC 1133B.8.6.1 and ADA/ABA 307.2

As Built Meas:	1	Quantity:	JOB
Description:	Protruding object in route of travel between 27" and 80" high		
As Built Desc:	28" at tree branch		
Solution:	Remove object or provide detectable warning		
Bar. Severity:	1 Necessary	Cost Estimate:	\$1,400.00
Implementation Priority:	4	Facility Function:	
Implementation Phase:		Implementation Date:	
Official Responsible:

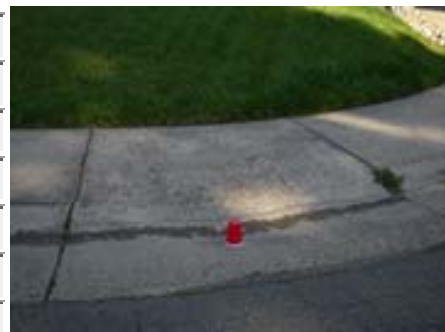
Field Date:	3/31/2011	Report Date:	3/31/2011	Barrier #:	6367
Location:	Janquil Wy and Los Serranos Wy - Corner A				
X Coordinate:	-121.24512				
Y Coordinate:	38.69924				
Barrier Area:	Curb Ramps				
Barrier Type:	No Curb Ramp - Depressed Existing Curb				
Code Ref:	CBC 1127B.5.1 and ADA/ABA 402.2

As Built Meas:	1	Quantity:	EACH
Description:	No compliant curb cut at corner (intersection)		
As Built Desc:	9.0% running slope at depressed area		
Solution:	Demolish existing and construct curb cut		
Bar. Severity:	1 Necessary	Cost Estimate:	\$2,500.00
Implementation Priority:	4	Facility Function:	
Implementation Phase:		Implementation Date:	
Official Responsible:			
Notes:	Two - way intersection corners A,D

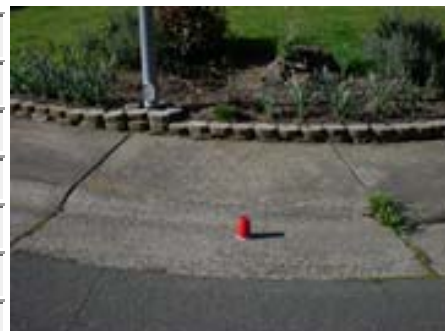
Field Date:	3/31/2011	Report Date:	3/31/2011	Barrier #:	6368
Location:	Janquil Wy and Los Serranos Wy - Corner D				
X Coordinate:	-121.24509				
Y Coordinate:	38.69915				
Barrier Area:	Curb Ramps				
Barrier Type:	No Curb Ramp - Depressed Existing Curb				
Code Ref:	CBC 1127B.5.1 and ADA/ABA 402.2

As Built Meas:	1	Quantity:	EACH
Description:	No compliant curb cut at corner (intersection)		
As Built Desc:	10.0% running slope at depressed area		
Solution:	Demolish existing and construct curb cut		
Bar. Severity:	1 Necessary	Cost Estimate:	\$2,500.00
Implementation Priority:	4	Facility Function:	
Implementation Phase:		Implementation Date:	
Official Responsible:			
Notes:	Two - way intersection corners A,D

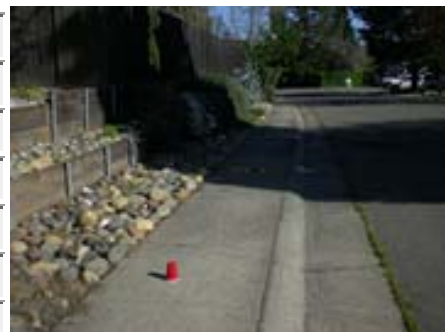
Field Date:	3/31/2011	Report Date:	3/31/2011	Barrier #:	6369
Location:	Janquil Wy - West				
X Coordinate:	-121.24508				
Y Coordinate:	38.69933				
Barrier Area:	Sidewalks				
Barrier Type:	Cross Slope - Existing (2.1% to 3.0%)				
Code Ref:	CBC 1133B.7.1.3 and ADA/ABA 403.3

As Built Meas:	202	Quantity:	LF
Description:	Cross slope exceeds 2.0% (2.1% to 3.0%)		
As Built Desc:	3.0% cross slope		
Solution:	Low severity barrier - no remediation recommended		
Bar. Severity:	4 Low Severity	Cost Estimate:	\$0.00
Implementation Priority:	4	Facility Function:	
Implementation Phase:		Implementation Date:	
Official Responsible:			
Notes:

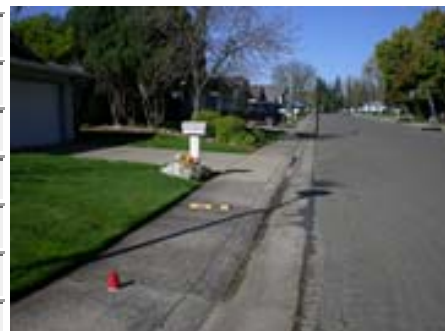
Field Date:	3/31/2011	Report Date:	3/31/2011	Barrier #:	6370A
Location:	Janquil Wy - South				
X Coordinate:	-121.24522				
Y Coordinate:	38.69989				
Barrier Area:	Sidewalks				
Barrier Type:	Cross Slope - Existing (4.1% to 4.9%)				
Code Ref:	CBC 1133B.7.1.3 and ADA/ABA 403.3

As Built Meas:	513	Quantity:	LF
Description:	Cross slope exceeds 2.0% (4.1% to 4.9%)		
As Built Desc:	4.2% cross slope		
Solution:	Demolish existing and construct new route		
Bar. Severity:	2 Recommended	Cost Estimate:	\$64,125.00
Implementation Priority:	4	Facility Function:	
Implementation Phase:		Implementation Date:	
Official Responsible:			
Notes:

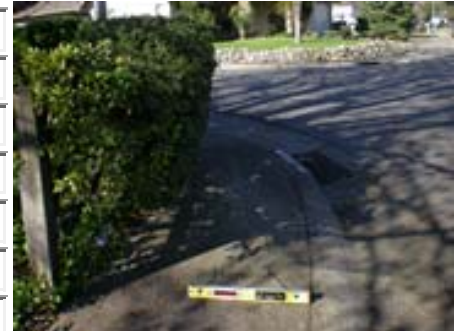
Barrier Type: Clear Width - New Construction

Code Ref: CBC 1133B.7.1

Description: Pedestrian route is not min. 48" wide

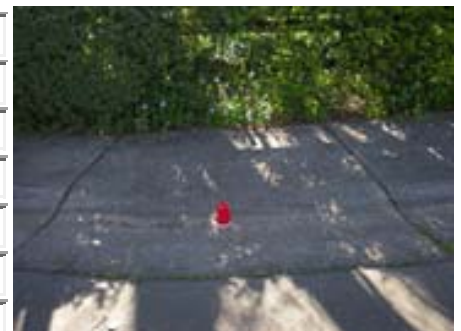
Barrier Type: No Curb Ramp - Depressed Existing Curb

Code Ref: CBC 1127B.5.1 and ADA/ABA 402.2

Description: No compliant curb cut at corner (intersection)

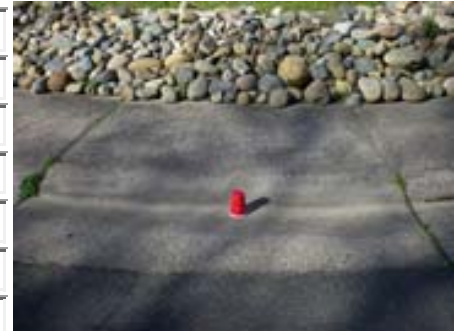
Field Date:	3/31/2011	Report Date:	3/31/2011	Barrier #:	6372
Location:	Janquil Wy and Goldwood Wy - Corner D				
X Coordinate:	-121.24716				
Y Coordinate:	38.69988				
Barrier Area:	Curb Ramps				
Barrier Type:	No Curb Ramp - Depressed Existing Curb				
Code Ref:	CBC 1127B.5.1 and ADA/ABA 402.2

As Built Meas:	1	Quantity:	EACH
Description:	No compliant curb cut at corner (intersection)		
As Built Desc:	9.1% running slope at depressed area		
Solution:	Demolish existing and construct curb cut		
Bar. Severity:	1 Necessary	Cost Estimate:	\$2,500.00
Implementation Priority:	4	Facility Function:	
Implementation Phase:		Implementation Date:	
Official Responsible:			
Notes:	Two - way intersection corners C,D

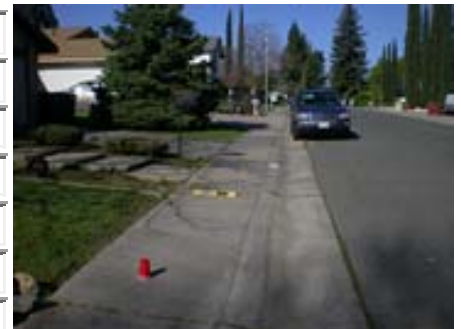
Field Date:	3/31/2011	Report Date:	3/31/2011	Barrier #:	6373
Location:	Janquil Wy - South				
X Coordinate:	-121.2473				
Y Coordinate:	38.69989				
Barrier Area:	Sidewalks				
Barrier Type:	Cross Slope - Existing (3.1% to 4.0%)				
Code Ref:	CBC 1133B.7.1.3 and ADA/ABA 403.3

As Built Meas:	361	Quantity:	LF
Description:	Cross slope exceeds 2.0% (3.1% to 4.0%)		
As Built Desc:	3.8% cross slope		
Solution:	Demolish existing and construct new route		
Bar. Severity:	3 Hindrance	Cost Estimate:	\$45,125.00
Implementation Priority:	4	Facility Function:	
Implementation Phase:		Implementation Date:	
Official Responsible:			
Notes:

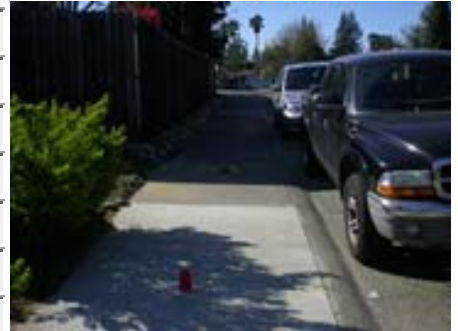
Field Date:	3/31/2011	Report Date:	3/31/2011	Barrier #:	6374
Location:	Menke Wy - East				
X Coordinate:	-121.2485				
Y Coordinate:	38.69981				
Barrier Area:	Sidewalks				
Barrier Type:	Cross Slope - Existing (4.1% to 4.9%)				
Code Ref:	CBC 1133B.7.1.3 and ADA/ABA 403.3

As Built Meas:	235	Quantity:	LF
Description:	Cross slope exceeds 2.0% (4.1% to 4.9%)		
As Built Desc:	4.1% cross slope		
Solution:	Demolish existing and construct new route		
Bar. Severity:	2 Recommended	Cost Estimate:	\$29,375.00
Implementation Priority:	4	Facility Function:	
Implementation Phase:		Implementation Date:	
Official Responsible:

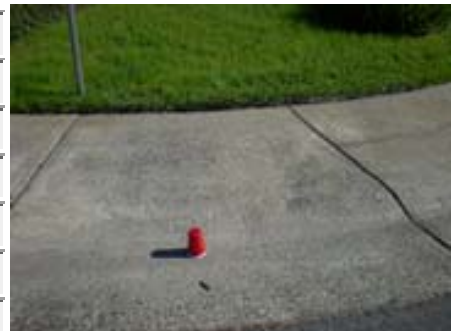
Field Date:	3/31/2011	Report Date:	3/31/2011	Barrier #:	6375
Location:	Menke Wy and Menke Wy Ct - Corner B				
X Coordinate:	-121.24835				
Y Coordinate:	38.69917				
Barrier Area:	Curb Ramps				
Barrier Type:	No Curb Ramp - Depressed Existing Curb				
Code Ref:	CBC 1127B.5.1 and ADA/ABA 402.2

As Built Meas:	1	Quantity:	EACH
Description:	No compliant curb cut at corner (intersection)		
As Built Desc:	9.7% running slope at depressed area		
Solution:	Demolish existing and construct curb cut		
Bar. Severity:	1 Necessary	Cost Estimate:	\$2,500.00
Implementation Priority:	4	Facility Function:	
Implementation Phase:		Implementation Date:	
Official Responsible:

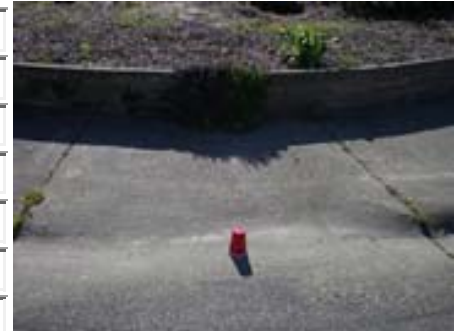
Barrier Type: No Curb Ramp - Depressed Existing Curb

Code Ref: CBC 1127B.5.1 and ADA/ABA 402.2

Description: No compliant curb cut at corner (intersection)

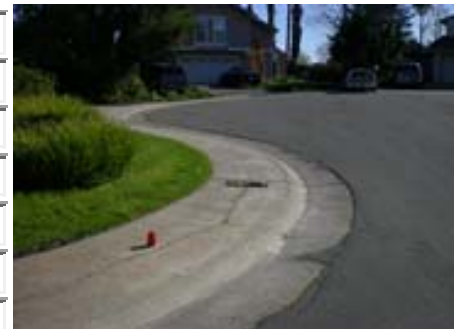
Barrier Type: Cross Slope - Existing (2.1% to 3.0%)

Code Ref: CBC 1133B.7.1.3 and ADA/ABA 403.3

Description: Cross slope exceeds 2.0% (2.1% to 3.0%)

Solution: Low severity barrier - no remediation recommended

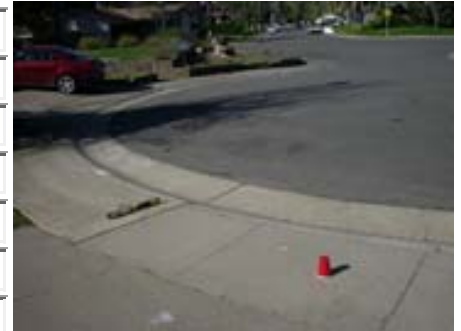
Barrier Type: Cross Slope - Existing (4.1% to 4.9%)

Code Ref: CBC 1133B.7.1.3 and ADA/ABA 403.3

Description: Cross slope exceeds 2.0% (4.1% to 4.9%)

Bar. Severity: 2 Recommended Cost Estimate: \$15,000.00 Status:

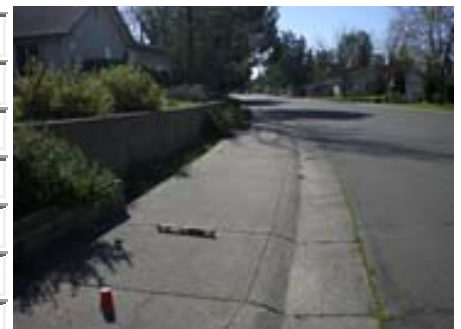
Barrier Type: Cross Slope - Existing (4.1% to 4.9%)

Code Ref: CBC 1133B.7.1.3 and ADA/ABA 403.3

Description: Cross slope exceeds 2.0% (4.1% to 4.9%)

Bar. Severity: 2 Recommended Cost Estimate: \$40,125.00 Status:

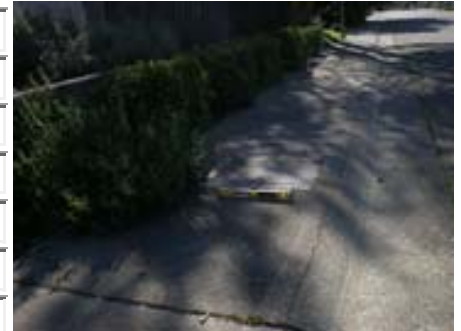
Barrier Type: Clear Width - New Construction

Code Ref: CBC 1133B.7.1

Description: Pedestrian route is not min. 48" wide

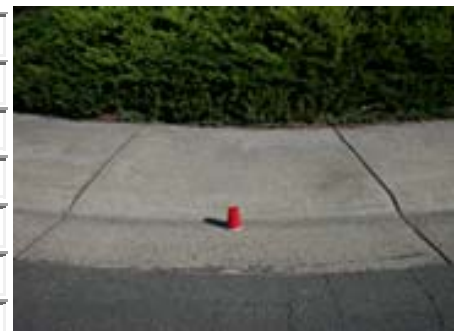
Barrier Type: No Curb Ramp - Depressed Existing Curb

Code Ref: CBC 1127B.5.1 and ADA/ABA 402.2

Description: No compliant curb cut at corner (intersection)

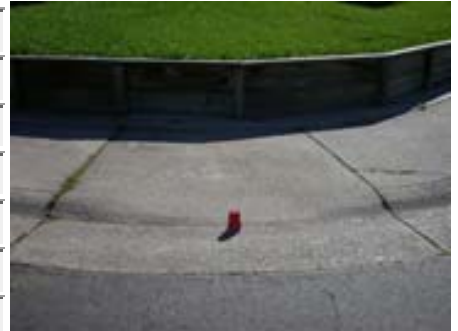
Field Date:	3/31/2011	Report Date:	3/31/2011	Barrier #:	6382
Location:	Menke Wy and Goldwood Wy - Corner C				
X Coordinate:	-121.24734				
Y Coordinate:	38.69833				
Barrier Area:	Curb Ramps				
Barrier Type:	No Curb Ramp - Depressed Existing Curb				
Code Ref:	CBC 1127B.5.1 and ADA/ABA 402.2

As Built Meas:	1	Quantity:	EACH
Description:	No compliant curb cut at corner (intersection)		
As Built Desc:	10.7% running slope at depressed area		
Solution:	Demolish existing and construct curb cut		
Bar. Severity:	1 Necessary	Cost Estimate:	\$2,500.00
Implementation Priority:	4	Facility Function:	
Implementation Phase:		Implementation Date:	
Official Responsible:			
Notes:	Two - way intersection corners B,C

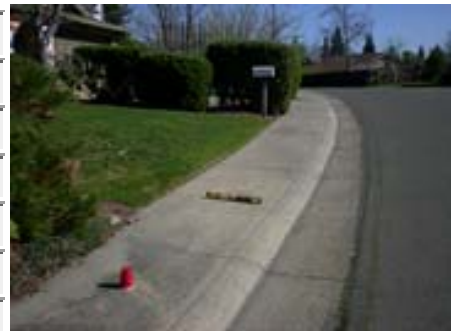
Field Date:	3/31/2011	Report Date:	3/31/2011	Barrier #:	6383
Location:	Goldwood Wy - West				
X Coordinate:	-121.24739				
Y Coordinate:	38.69848				
Barrier Area:	Sidewalks				
Barrier Type:	Cross Slope - Existing (4.1% to 4.9%)				
Code Ref:	CBC 1133B.7.1.3 and ADA/ABA 403.3

As Built Meas:	543	Quantity:	LF
Description:	Cross slope exceeds 2.0% (4.1% to 4.9%)		
As Built Desc:	4.2% cross slope		
Solution:	Demolish existing and construct new route		
Bar. Severity:	2 Recommended	Cost Estimate:	\$67,875.00
Implementation Priority:	4	Facility Function:	
Implementation Phase:		Implementation Date:	
Official Responsible:			
Notes:

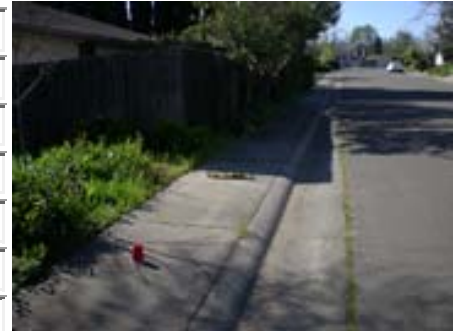
Field Date:	3/31/2011	Report Date:	3/31/2011	Barrier #:	6384A
Location:	Goldwood Wy - East				
X Coordinate:	-121.24705				
Y Coordinate:	38.69983				
Barrier Area:	Sidewalks				
Barrier Type:	Cross Slope - Existing (3.1% to 4.0%)				
Code Ref:	CBC 1133B.7.1.3 and ADA/ABA 403.3

As Built Meas:	120	Quantity:	LF
Description:	Cross slope exceeds 2.0% (3.1% to 4.0%)		
As Built Desc:	4.1% cross slope		
Solution:	Demolish existing and construct new route		
Bar. Severity:	3 Hindrance	Cost Estimate:	\$15,000.00
Implementation Priority:	4	Facility Function:	
Implementation Phase:		Implementation Date:	
Official Responsible:			
Notes:

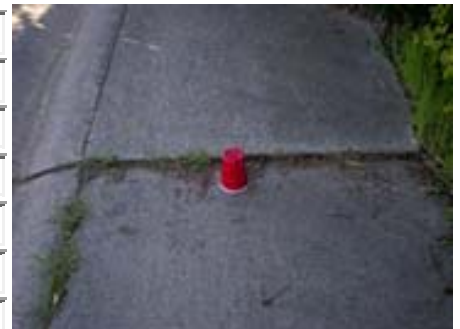
Field Date:	3/31/2011	Report Date:	3/31/2011	Barrier #:	6384B
Location:	Goldwood Wy - East				
X Coordinate:	-121.24701				
Y Coordinate:	38.69969				
Barrier Area:	Sidewalks				
Barrier Type:	Abrupt Change in Level - > 1/2"				
Code Ref:	CBC 1133B.7.1 and ADA/ABA 303.3

As Built Meas:	4	Quantity:	LF
Description:	Change in level greater than 1/2"		
As Built Desc:	1/2" lip in sidewalk surface		
Solution:	Grind or repair sidewalk to remove trip hazard		
Bar. Severity:	1 Necessary	Cost Estimate:	\$1,000.00
Implementation Priority:	4	Facility Function:	
Implementation Phase:		Implementation Date:	
Official Responsible:			
Notes:

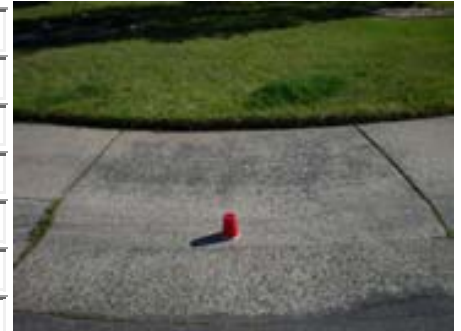
Barrier Type: No Curb Ramp - Depressed Existing Curb

Code Ref: CBC 1127B.5.1 and ADA/ABA 402.2

As Built Meas: 1 Quantity: EACH

Description: No compliant curb cut at corner (intersection)

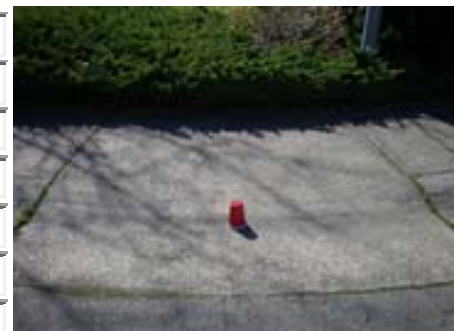
Barrier Type: No Curb Ramp - Depressed Existing Curb

Code Ref: CBC 1127B.5.1 and ADA/ABA 402.2

As Built Meas: 1 Quantity: EACH

Description: No compliant curb cut at corner (intersection)

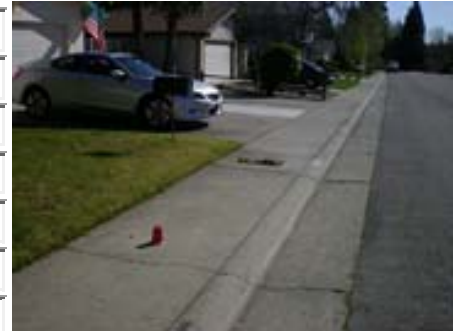
Field Date:	3/31/2011	Report Date:	3/31/2011	Barrier #:	6387A
Location:	Los Serranos Wy - North				
X Coordinate:	-121.24691				
Y Coordinate:	38.69928				
Barrier Area:	Sidewalks				
Barrier Type:	Cross Slope - Existing (4.1% to 4.9%)				
Code Ref:	CBC 1133B.7.1.3 and ADA/ABA 403.3

As Built Meas:	507	Quantity:	LF
Description:	Cross slope exceeds 2.0% (4.1% to 4.9%)		
As Built Desc:	4.8% cross slope		
Solution:	Demolish existing and construct new route		
Bar. Severity:	2 Recommended	Cost Estimate:	\$63,375.00
Implementation Priority:	4	Facility Function:	
Implementation Phase:		Implementation Date:	
Official Responsible:

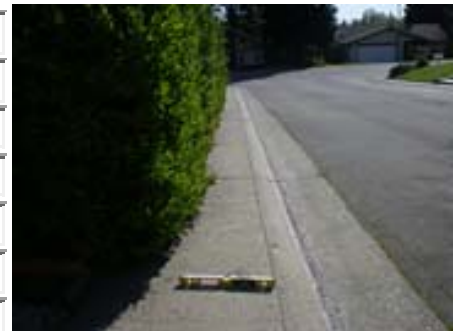
Field Date:	3/31/2011	Report Date:	3/31/2011	Barrier #:	6387B
Location:	Los Serranos Wy -North				
X Coordinate:	-121.24561				
Y Coordinate:	38.69931				
Barrier Area:	Sidewalks				
Barrier Type:	Clear Width - Existing ($\leq 31"$ or less)				
Code Ref:	CBC 1133B.7.1

As Built Meas:	1	Quantity:	LF
Description:	Pedestrian route is not min. 48" wide ($\leq 31"$ or less)		
As Built Desc:	24" clear width due to foliage		
Solution:	Trim foliage to provide min. 48" clear width		
Bar. Severity:	1 Necessary	Cost Estimate:	\$125.00
Implementation Priority:	4	Facility Function:	
Implementation Phase:		Implementation Date:	
Official Responsible:

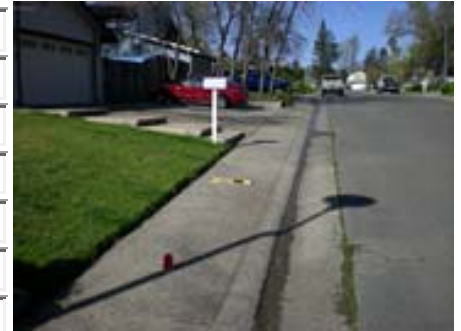
Barrier Type: Cross Slope - Existing (3.1% to 4.0%)

Code Ref: CBC 1133B.7.1.3 and ADA/ABA 403.3

As Built Meas: 262 Quantity: LF

Description: Cross slope exceeds 2.0% (3.1% to 4.0%)

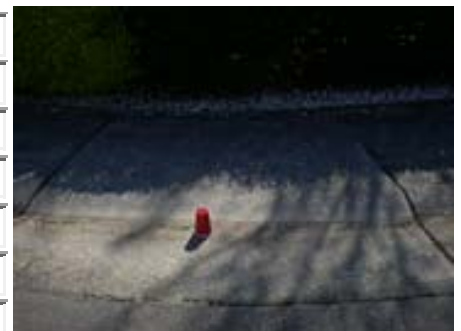
Barrier Type: No Curb Ramp - Depressed Existing Curb

Code Ref: CBC 1127B.5.1 and ADA/ABA 402.2

As Built Meas: 1 Quantity: EACH

Description: No compliant curb cut at corner (intersection)

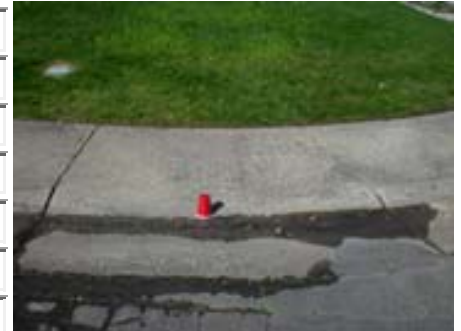
Field Date:	3/31/2011	Report Date:	3/31/2011	Barrier #:	6390
Location:	Los Serranos Wy and Quailwood Wy - Corner D				
X Coordinate:	-121.24619				
Y Coordinate:	38.69911				
Barrier Area:	Curb Ramps				
Barrier Type:	No Curb Ramp - Depressed Existing Curb				
Code Ref:	CBC 1127B.5.1 and ADA/ABA 402.2

As Built Meas:	1	Quantity:	EACH
Description:	No compliant curb cut at corner (intersection)		
As Built Desc:	10.7% running slope at depressed area		
Solution:	Demolish existing and construct curb cut		
Bar. Severity:	1 Necessary	Cost Estimate:	\$2,500.00
Implementation Priority:	4	Facility Function:	
Implementation Phase:		Implementation Date:	
Official Responsible:

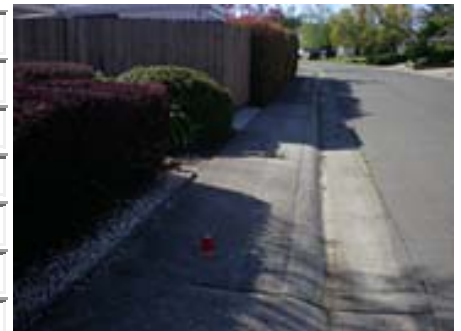
Field Date:	3/31/2011	Report Date:	3/31/2011	Barrier #:	6391
Location:	Quailwood Wy - East				
X Coordinate:	-121.24611				
Y Coordinate:	38.69906				
Barrier Area:	Sidewalks				
Barrier Type:	Cross Slope - Existing (3.1% to 4.0%)				
Code Ref:	CBC 1133B.7.1.3 and ADA/ABA 403.3

As Built Meas:	413	Quantity:	LF
Description:	Cross slope exceeds 2.0% (3.1% to 4.0%)		
As Built Desc:	3.7% cross slope		
Solution:	Demolish existing and construct new route		
Bar. Severity:	3 Hindrance	Cost Estimate:	\$51,625.00
Implementation Priority:	4	Facility Function:	
Implementation Phase:		Implementation Date:	
Official Responsible:

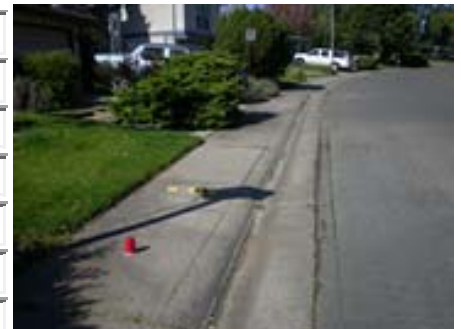
Field Date:	3/31/2011	Report Date:	3/31/2011	Barrier #:	6393
Location:	Quailwood Wy - South				
X Coordinate:	-121.24461				
Y Coordinate:	38.69775				
Barrier Area:	Sidewalks				
Barrier Type:	Cross Slope - Existing (3.1% to 4.0%)				
Code Ref:	CBC 1133B.7.1.3 and ADA/ABA 403.3

As Built Meas:	343	Quantity:	LF
Description:	Cross slope exceeds 2.0% (3.1% to 4.0%)		
As Built Desc:	3.1% cross slope		
Solution:	Demolish existing and construct new route		
Bar. Severity:	3 Hindrance	Cost Estimate:	\$42,875.00
Implementation Priority:	4	Facility Function:	
Implementation Phase:		Implementation Date:	
Official Responsible:

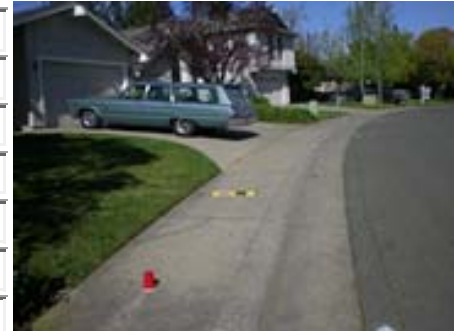
Barrier Type: Cross Slope - Existing (3.1% to 4.0%)

Code Ref: CBC 1133B.7.1.3 and ADA/ABA 403.3

As Built Meas: 438 Quantity: LF

Description: Cross slope exceeds 2.0% (3.1% to 4.0%)

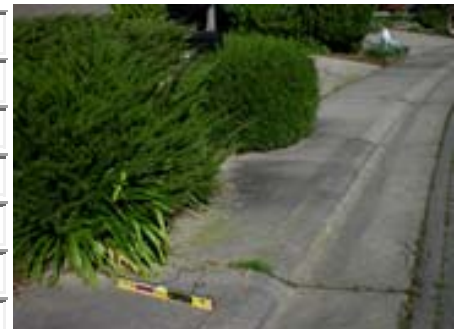
Barrier Type: Clear Width - Existing ($\leq 31"$ or less)

Code Ref: CBC 1133B.7.1

As Built Meas: 12 Quantity: LF

Description: Pedestrian route is not min. 48" wide ($\leq 31"$ or less)

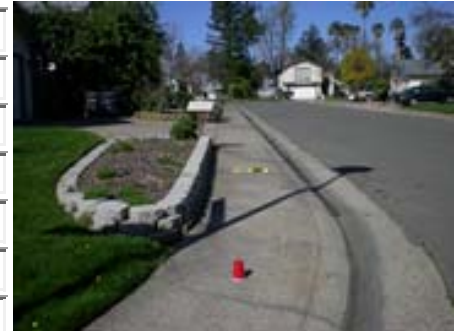
Barrier Type: Cross Slope - Existing (3.1% to 4.0%)

Code Ref: CBC 1133B.7.1.3 and ADA/ABA 403.3

As Built Meas: 206 Quantity: LF

Description: Cross slope exceeds 2.0% (3.1% to 4.0%)

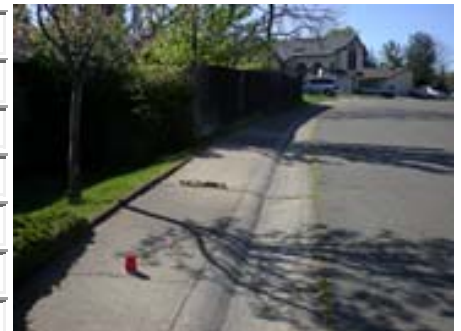
Barrier Type: Cross Slope - Existing (3.1% to 4.0%)

Code Ref: CBC 1133B.7.1.3 and ADA/ABA 403.3

As Built Meas: 291 Quantity: LF

Description: Cross slope exceeds 2.0% (3.1% to 4.0%)

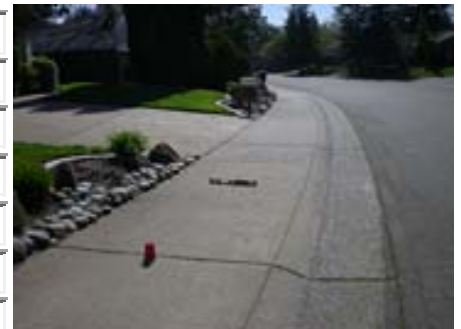
Field Date:	3/31/2011	Report Date:	3/31/2011	Barrier #:	6399
Location:	Menke Wy - North				
X Coordinate:	-121.24584				
Y Coordinate:	38.69723				
Barrier Area:	Sidewalks				
Barrier Type:	Cross Slope - Existing (4.1% to 4.9%)				
Code Ref:	CBC 1133B.7.1.3 and ADA/ABA 403.3

As Built Meas:	246	Quantity:	LF
Description:	Cross slope exceeds 2.0% (4.1% to 4.9%)		
As Built Desc:	4.9% cross slope		
Solution:	Demolish existing and construct new route		
Bar. Severity:	2 Recommended	Cost Estimate:	\$30,750.00
Implementation Priority:	4	Facility Function:	
Implementation Phase:		Implementation Date:	
Official Responsible:

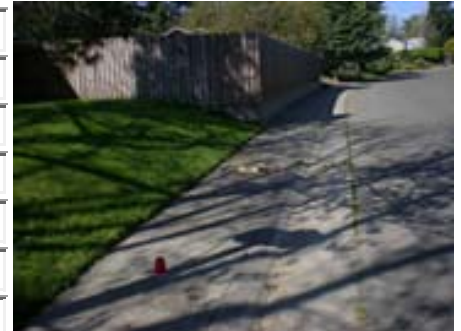
Barrier Type: Cross Slope - Existing (4.1% to 4.9%)

Code Ref: CBC 1133B.7.1.3 and ADA/ABA 403.3

As Built Meas: 246 Quantity: LF

Description: Cross slope exceeds 2.0% (4.1% to 4.9%)

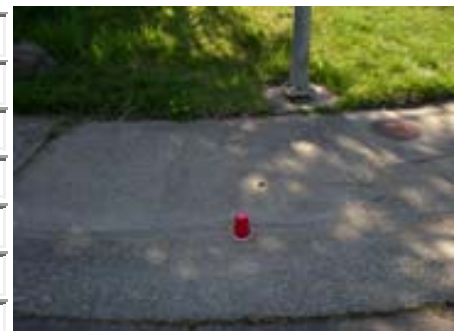
Barrier Type: No Curb Ramp - Depressed Existing Curb

Code Ref: CBC 1127B.5.1 and ADA/ABA 402.2

As Built Meas: 1 Quantity: EACH

Description: No compliant curb cut at corner (intersection)

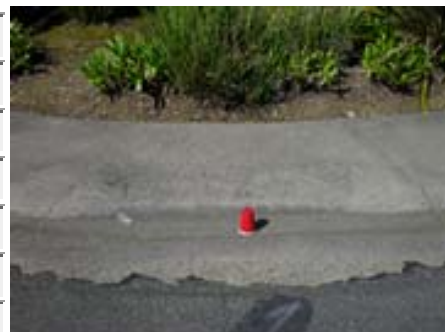
Field Date:	3/31/2011	Report Date:	3/31/2011	Barrier #:	6402
Location:	Menke Wy and Menke Wy Ct - Corner D				
X Coordinate:	-121.24557				
Y Coordinate:	38.69694				
Barrier Area:	Curb Ramps				
Barrier Type:	No Curb Ramp - Depressed Existing Curb				
Code Ref:	CBC 1127B.5.1 and ADA/ABA 402.2

As Built Meas:	1	Quantity:	EACH
Description:	No compliant curb cut at corner (intersection)		
As Built Desc:	11.4% running slope at depressed area		
Solution:	Demolish existing and construct curb cut		
Bar. Severity:	1 Necessary	Cost Estimate:	\$2,500.00
Implementation Priority:	4	Facility Function:	
Implementation Phase:		Implementation Date:	
Official Responsible:			
Notes:	Two - way intersection corners C,D

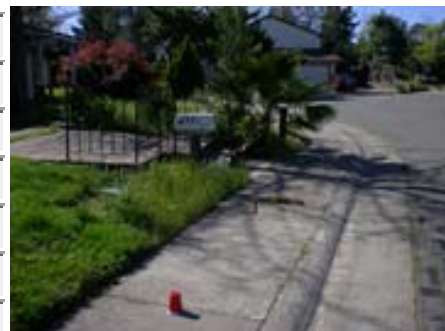
Field Date:	3/31/2011	Report Date:	3/31/2011	Barrier #:	6403A
Location:	Menke Wy Ct - East				
X Coordinate:	-121.2455				
Y Coordinate:	38.69685				
Barrier Area:	Sidewalks				
Barrier Type:	Cross Slope - Existing (4.1% to 4.9%)				
Code Ref:	CBC 1133B.7.1.3 and ADA/ABA 403.3

As Built Meas:	157	Quantity:	LF
Description:	Cross slope exceeds 2.0% (4.1% to 4.9%)		
As Built Desc:	4.1% cross slope		
Solution:	Demolish existing and construct new route		
Bar. Severity:	2 Recommended	Cost Estimate:	\$19,625.00
Implementation Priority:	4	Facility Function:	
Implementation Phase:		Implementation Date:	
Official Responsible:			
Notes:

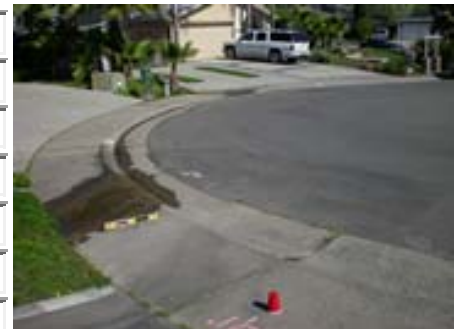
Field Date:	3/31/2011	Report Date:	3/31/2011	Barrier #:	6404A
Location:	Menke Wy Ct - West				
X Coordinate:	-121.24573				
Y Coordinate:	38.69656				
Barrier Area:	Sidewalks				
Barrier Type:	Cross Slope - Existing (5.0% or more)				
Code Ref:	CBC 1133B.7.1.3 and ADA/ABA 403.3

As Built Meas:	163	Quantity:	LF
Description:	Cross slope exceeds 2.0% (5.0% or more)		
As Built Desc:	5.5% cross slope		
Solution:	Demolish existing and construct new route		
Bar. Severity:	1 Necessary	Cost Estimate:	\$20,375.00
Implementation Priority:	4	Facility Function:	
Implementation Phase:		Implementation Date:	
Official Responsible:

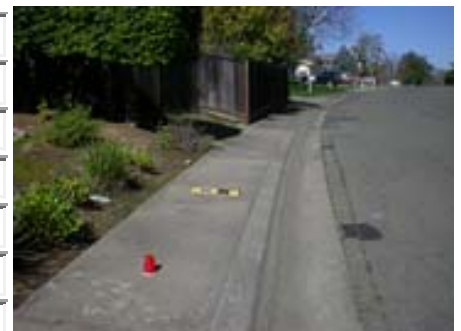
Barrier Type: Cross Slope - Existing (4.1% to 4.9%)

Code Ref: CBC 1133B.7.1.3 and ADA/ABA 403.3

As Built Meas: 563 Quantity: LF

Description: Cross slope exceeds 2.0% (4.1% to 4.9%)

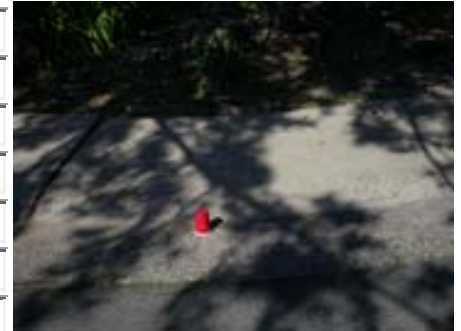
Field Date:	3/31/2011	Report Date:	3/31/2011	Barrier #:	6406
Location:	Menke Wy and Dalmeny Wy - Corner A				
X Coordinate:	-121.24724				
Y Coordinate:	38.69807				
Barrier Area:	Curb Ramps				
Barrier Type:	No Curb Ramp - Depressed Existing Curb				
Code Ref:	CBC 1127B.5.1 and ADA/ABA 402.2

As Built Meas:	1	Quantity:	EACH
Description:	No compliant curb cut at corner (intersection)		
As Built Desc:	9.8% running slope at depressed area		
Solution:	Demolish existing and construct curb cut		
Bar. Severity:	1 Necessary	Cost Estimate:	\$2,500.00
Implementation Priority:	4	Facility Function:	
Implementation Phase:		Implementation Date:	
Official Responsible:			
Notes:	Two - way intersection corners A,D

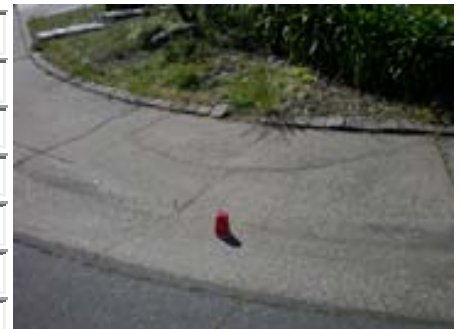
Field Date:	3/31/2011	Report Date:	3/31/2011	Barrier #:	6407
Location:	Menke Wy and Dalmeny Wy - Corner D				
X Coordinate:	-121.2471				
Y Coordinate:	38.69797				
Barrier Area:	Curb Ramps				
Barrier Type:	No Curb Ramp - Depressed Existing Curb				
Code Ref:	CBC 1127B.5.1 and ADA/ABA 402.2

As Built Meas:	1	Quantity:	EACH
Description:	No compliant curb cut at corner (intersection)		
As Built Desc:	10.1% running slope at depressed area		
Solution:	Demolish existing and construct curb cut		
Bar. Severity:	1 Necessary	Cost Estimate:	\$2,500.00
Implementation Priority:	4	Facility Function:	
Implementation Phase:		Implementation Date:	
Official Responsible:			
Notes:	Two - way intersection corners A,D

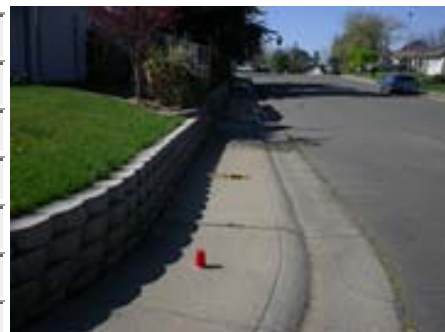
Field Date:	3/31/2011	Report Date:	3/31/2011	Barrier #:	6408
Location:	Dalmeny Wy - South				
X Coordinate:	-121.24717				
Y Coordinate:	38.69791				
Barrier Area:	Sidewalks				
Barrier Type:	Cross Slope - Existing (5.0% or more)				
Code Ref:	CBC 1133B.7.1.3 and ADA/ABA 403.3

As Built Meas:	218	Quantity:	LF
Description:	Cross slope exceeds 2.0% (5.0% or more)		
As Built Desc:	6.5% cross slope		
Solution:	Demolish existing and construct new route		
Bar. Severity:	1 Necessary	Cost Estimate:	\$27,250.00
Implementation Priority:	4	Facility Function:	
Implementation Phase:		Implementation Date:	
Official Responsible:			
Notes:

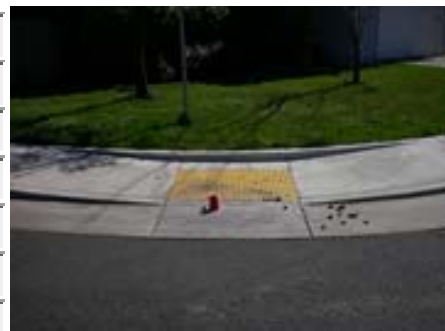
Field Date:	3/31/2011	Report Date:	3/31/2011	Barrier #:	6409
Location:	Dalmeny Wy and Brookridge Ct - Corner C				
X Coordinate:	-121.2477				
Y Coordinate:	38.6975				
Barrier Area:	Curb Ramps				
Barrier Type:	12" Grooves - Existing (>5.0%)				
Code Ref:	CBC 1127B.5.6

As Built Meas:	1	Quantity:	EACH
Description:	12" grooves at top of curb ramp are not level (>5.0%)		
As Built Desc:	5.0% at 12" grooves		
Solution:	Demolish existing and construct new curb ramp		
Bar. Severity:	1 Necessary	Cost Estimate:	\$2,500.00
Implementation Priority:	4	Facility Function:	
Implementation Phase:		Implementation Date:	
Official Responsible:			
Notes:	Two - way intersection corners C,D. Corner D compliant

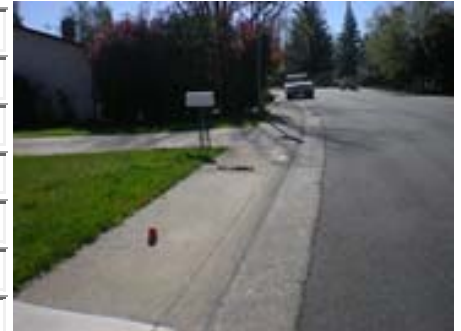
Barrier Type: Cross Slope - Existing (4.1% to 4.9%)

Code Ref: CBC 1133B.7.1.3 and ADA/ABA 403.3

As Built Meas: 600 Quantity: LF

Description: Cross slope exceeds 2.0% (4.1% to 4.9%)

Bar. Severity: 2 Recommended Cost Estimate: \$75,000.00 Status:

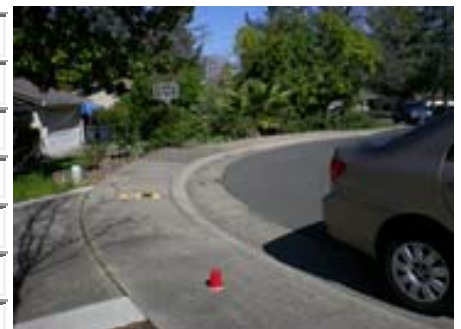
Barrier Type: Cross Slope - Existing (4.1% to 4.9%)

Code Ref: CBC 1133B.7.1.3 and ADA/ABA 403.3

As Built Meas: 566 Quantity: LF

Description: Cross slope exceeds 2.0% (4.1% to 4.9%)

Bar. Severity: 2 Recommended Cost Estimate: \$70,750.00 Status:

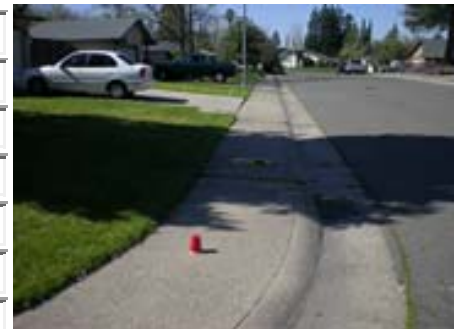
Field Date:	3/31/2011	Report Date:	3/31/2011	Barrier #:	6412
Location:	Dalmeny Wy - South				
X Coordinate:	-121.24787				
Y Coordinate:	38.69745				
Barrier Area:	Sidewalks				
Barrier Type:	Cross Slope - Existing (4.1% to 4.9%)				
Code Ref:	CBC 1133B.7.1.3 and ADA/ABA 403.3

As Built Meas:	413	Quantity:	LF
Description:	Cross slope exceeds 2.0% (4.1% to 4.9%)		
As Built Desc:	4.8% cross slope		
Solution:	Demolish existing and construct new route		
Bar. Severity:	2 Recommended	Cost Estimate:	\$51,625.00
Implementation Priority:	4	Facility Function:	
Implementation Phase:		Implementation Date:	
Official Responsible:			
Notes:

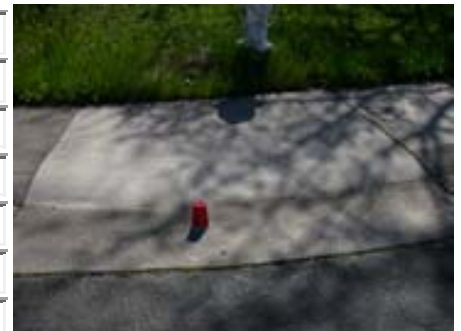
Field Date:	3/31/2011	Report Date:	3/31/2011	Barrier #:	6414
Location:	Dalmeny Wy and Old Ranch Rd - Corner C				
X Coordinate:	-121.24907				
Y Coordinate:	38.6968				
Barrier Area:	Curb Ramps				
Barrier Type:	No Curb Ramp - Depressed Existing Curb				
Code Ref:	CBC 1127B.5.1 and ADA/ABA 402.2

As Built Meas:	1	Quantity:	EACH
Description:	No compliant curb cut at corner (intersection)		
As Built Desc:	7.4% running slope at depressed area		
Solution:	Demolish existing and construct curb cut		
Bar. Severity:	1 Necessary	Cost Estimate:	\$2,500.00
Implementation Priority:	4	Facility Function:	
Implementation Phase:		Implementation Date:	
Official Responsible:			
Notes:	Two - way intersection corners B,C

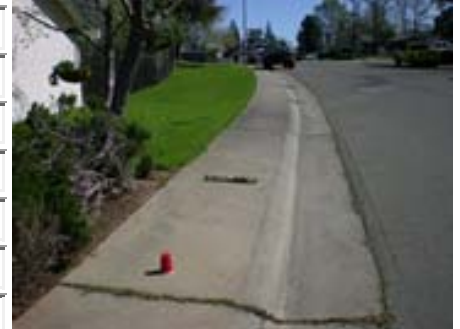
Field Date:	3/31/2011	Report Date:	3/31/2011	Barrier #:	6415
Location:	Dalmeny Wy - North				
X Coordinate:	-121.24903				
Y Coordinate:	38.69695				
Barrier Area:	Sidewalks				
Barrier Type:	Cross Slope - Existing (5.0% or more)				
Code Ref:	CBC 1133B.7.1.3 and ADA/ABA 403.3

As Built Meas:	698	Quantity:	LF
Description:	Cross slope exceeds 2.0% (5.0% or more)		
As Built Desc:	5.3% cross slope		
Solution:	Demolish existing and construct new route		
Bar. Severity:	1 Necessary	Cost Estimate:	\$87,250.00
Implementation Priority:	4	Facility Function:	
Implementation Phase:		Implementation Date:	
Official Responsible:

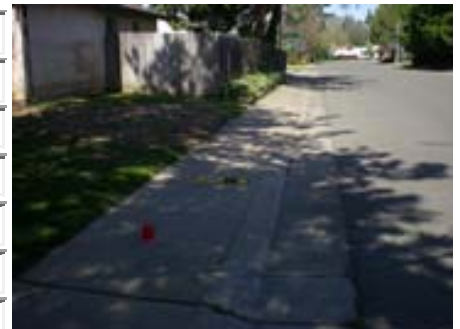
Field Date:	3/31/2011	Report Date:	3/31/2011	Barrier #:	6416
Location:	Menke Wy - West				
X Coordinate:	-121.24731				
Y Coordinate:	38.69816				
Barrier Area:	Sidewalks				
Barrier Type:	Cross Slope - Existing (4.1% to 4.9%)				
Code Ref:	CBC 1133B.7.1.3 and ADA/ABA 403.3

As Built Meas:	203	Quantity:	LF
Description:	Cross slope exceeds 2.0% (4.1% to 4.9%)		
As Built Desc:	4.2% cross slope		
Solution:	Demolish existing and construct new route		
Bar. Severity:	2 Recommended	Cost Estimate:	\$25,375.00
Implementation Priority:	4	Facility Function:	
Implementation Phase:		Implementation Date:	
Official Responsible:

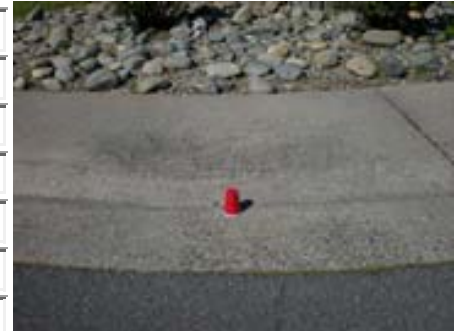
Field Date:	3/31/2011	Report Date:	3/31/2011	Barrier #:	6417
Location:	Menke Wy and Corrick Ct - Corner A				
X Coordinate:	-121.24795				
Y Coordinate:	38.69858				
Barrier Area:	Curb Ramps				
Barrier Type:	No Curb Ramp - Depressed Existing Curb				
Code Ref:	CBC 1127B.5.1 and ADA/ABA 402.2

As Built Meas:	1	Quantity:	EACH
Description:	No compliant curb cut at corner (intersection)		
As Built Desc:	8.3% running slope at depressed area		
Solution:	Demolish existing and construct curb cut		
Bar. Severity:	1 Necessary	Cost Estimate:	\$2,500.00
Implementation Priority:	4	Facility Function:	
Implementation Phase:		Implementation Date:	
Official Responsible:			
Notes:	Two - way intersection corners A,D

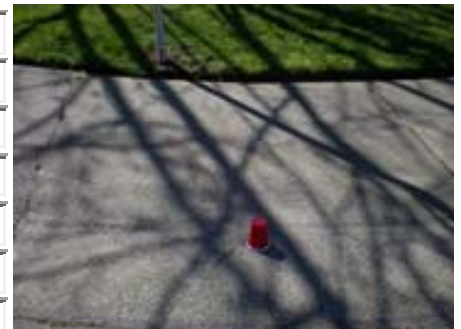
Field Date:	3/31/2011	Report Date:	3/31/2011	Barrier #:	6418
Location:	Menke Wy and Corrick Ct - Corner D				
X Coordinate:	-121.24783				
Y Coordinate:	38.69852				
Barrier Area:	Curb Ramps				
Barrier Type:	No Curb Ramp - Depressed Existing Curb				
Code Ref:	CBC 1127B.5.1 and ADA/ABA 402.2

As Built Meas:	1	Quantity:	EACH
Description:	No compliant curb cut at corner (intersection)		
As Built Desc:	8.6% running slope at depressed area		
Solution:	Demolish existing and construct curb cut		
Bar. Severity:	1 Necessary	Cost Estimate:	\$2,500.00
Implementation Priority:	4	Facility Function:	
Implementation Phase:		Implementation Date:	
Official Responsible:			
Notes:	Two - way intersection corners A,D

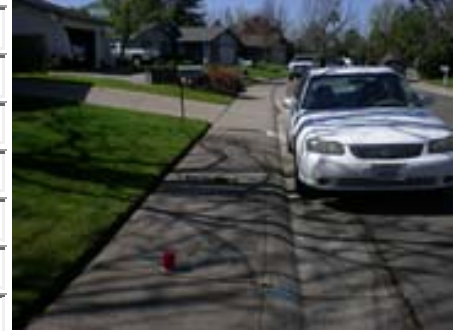
Field Date:	3/31/2011	Report Date:	3/31/2011	Barrier #:	6419A
Location:	Corrick Ct - South				
X Coordinate:	-121.24789				
Y Coordinate:	38.69846				
Barrier Area:	Sidewalks				
Barrier Type:	Cross Slope - Existing (4.1% to 4.9%)				
Code Ref:	CBC 1133B.7.1.3 and ADA/ABA 403.3

As Built Meas:	409	Quantity:	LF
Description:	Cross slope exceeds 2.0% (4.1% to 4.9%)		
As Built Desc:	4.6% cross slope		
Solution:	Demolish existing and construct new route		
Bar. Severity:	2 Recommended	Cost Estimate:	\$51,125.00
Implementation Priority:	4	Facility Function:	
Implementation Phase:		Implementation Date:	
Official Responsible:

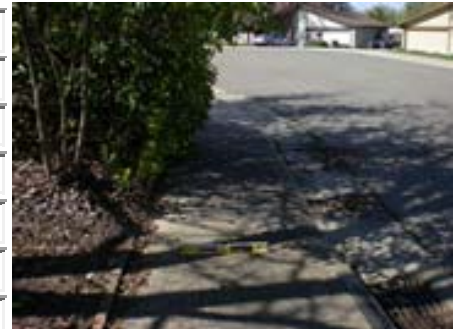
Field Date:	3/31/2011	Report Date:	3/31/2011	Barrier #:	6419B
Location:	Corrick Ct - South				
X Coordinate:	-121.24854				
Y Coordinate:	38.69808				
Barrier Area:	Sidewalks				
Barrier Type:	Clear Width - Existing ($\leq 31"$ or less)				
Code Ref:	CBC 1133B.7.1

As Built Meas:	1	Quantity:	LF
Description:	Pedestrian route is not min. 48" wide ($\leq 31"$ or less)		
As Built Desc:	24" clear width due to foliage		
Solution:	Trim foliage to provide min. 48" clear width		
Bar. Severity:	1 Necessary	Cost Estimate:	\$125.00
Implementation Priority:	4	Facility Function:	
Implementation Phase:		Implementation Date:	
Official Responsible:

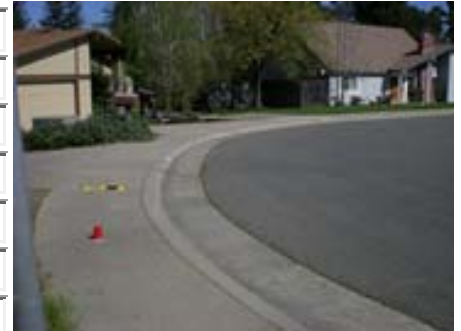
Field Date:	3/31/2011	Report Date:	3/31/2011	Barrier #:	6420A
Location:	Corrick Ct - North				
X Coordinate:	-121.24898				
Y Coordinate:	38.69789				
Barrier Area:	Sidewalks				
Barrier Type:	Cross Slope - Existing (5.0% or more)				
Code Ref:	CBC 1133B.7.1.3 and ADA/ABA 403.3

As Built Meas:	452	Quantity:	LF
Description:	Cross slope exceeds 2.0% (5.0% or more)		
As Built Desc:	5.3% cross slope		
Solution:	Demolish existing and construct new route		
Bar. Severity:	1 Necessary	Cost Estimate:	\$56,500.00
Implementation Priority:	4	Facility Function:	
Implementation Phase:		Implementation Date:	
Official Responsible:

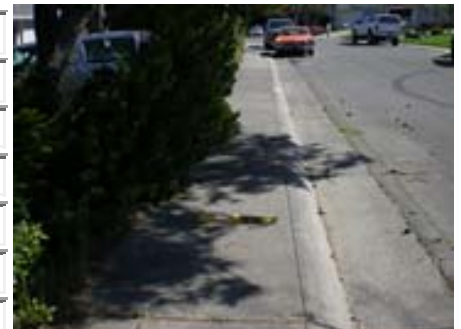
Field Date:	3/31/2011	Report Date:	3/31/2011	Barrier #:	6420B
Location:	Corrick Ct - North				
X Coordinate:	-121.24864				
Y Coordinate:	38.69814				
Barrier Area:	Sidewalks				
Barrier Type:	Clear Width - Existing ($\leq 31"$ or less)				
Code Ref:	CBC 1133B.7.1

As Built Meas:	1	Quantity:	LF
Description:	Pedestrian route is not min. 48" wide ($\leq 31"$ or less)		
As Built Desc:	24" clear width due to foliage		
Solution:	Trim foliage to provide min. 48" clear width		
Bar. Severity:	1 Necessary	Cost Estimate:	\$125.00
Implementation Priority:	4	Facility Function:	
Implementation Phase:		Implementation Date:	
Official Responsible:

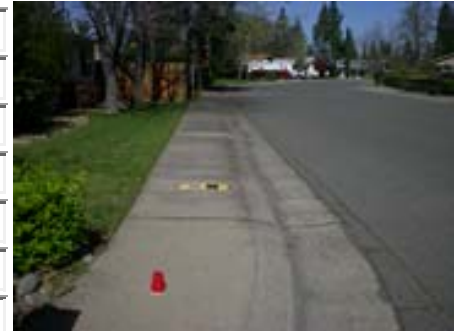
Field Date:	3/31/2011	Report Date:	3/31/2011	Barrier #:	6421
Location:	Menke Wy - West				
X Coordinate:	-121.24802				
Y Coordinate:	38.69867				
Barrier Area:	Sidewalks				
Barrier Type:	Cross Slope - Existing (3.1% to 4.0%)				
Code Ref:	CBC 1133B.7.1.3 and ADA/ABA 403.3

As Built Meas:	180	Quantity:	LF
Description:	Cross slope exceeds 2.0% (3.1% to 4.0%)		
As Built Desc:	3.1% cross slope		
Solution:	Demolish existing and construct new route		
Bar. Severity:	3 Hindrance	Cost Estimate:	\$22,500.00
Implementation Priority:	4	Facility Function:	
Implementation Phase:		Implementation Date:	
Official Responsible:

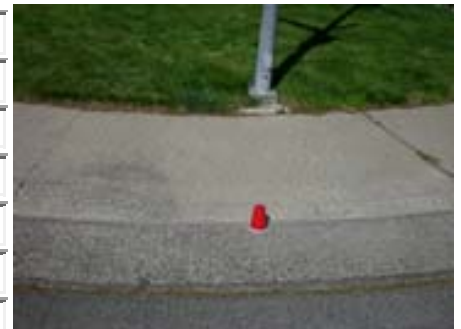
Field Date:	3/31/2011	Report Date:	3/31/2011	Barrier #:	6422
Location:	Menke Wy and Amsell Ct - Corner A				
X Coordinate:	-121.24848				
Y Coordinate:	38.69911				
Barrier Area:	Curb Ramps				
Barrier Type:	No Curb Ramp - Depressed Existing Curb				
Code Ref:	CBC 1127B.5.1 and ADA/ABA 402.2

As Built Meas:	1	Quantity:	EACH
Description:	No compliant curb cut at corner (intersection)		
As Built Desc:	8.6% running slope at depressed area		
Solution:	Demolish existing and construct curb cut		
Bar. Severity:	1 Necessary	Cost Estimate:	\$2,500.00
Implementation Priority:	4	Facility Function:	
Implementation Phase:		Implementation Date:	
Official Responsible:

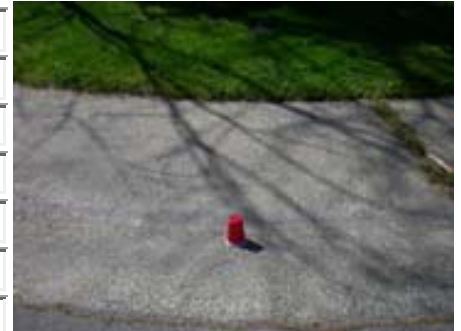
Field Date:	3/31/2011	Report Date:	3/31/2011	Barrier #:	6423
Location:	Menke Wy and Amsell Ct - Corner D				
X Coordinate:	-121.24843				
Y Coordinate:	38.699				
Barrier Area:	Curb Ramps				
Barrier Type:	No Curb Ramp - Depressed Existing Curb				
Code Ref:	CBC 1127B.5.1 and ADA/ABA 402.2

As Built Meas:	1	Quantity:	EACH
Description:	No compliant curb cut at corner (intersection)		
As Built Desc:	10.0% running slope at depressed area		
Solution:	Demolish existing and construct curb cut		
Bar. Severity:	1 Necessary	Cost Estimate:	\$2,500.00
Implementation Priority:	4	Facility Function:	
Implementation Phase:		Implementation Date:	
Official Responsible:			
Notes:	Two - way intersection corners A,D

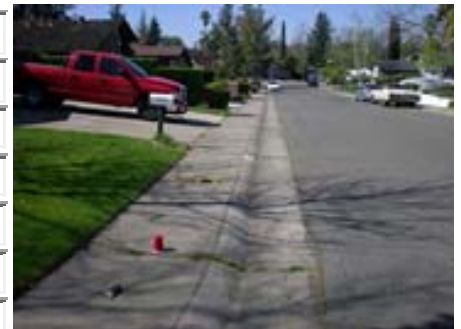
Field Date:	3/31/2011	Report Date:	3/31/2011	Barrier #:	6424A
Location:	Amsell Ct - South				
X Coordinate:	-121.24853				
Y Coordinate:	38.69898				
Barrier Area:	Sidewalks				
Barrier Type:	Cross Slope - Existing (4.1% to 4.9%)				
Code Ref:	CBC 1133B.7.1.3 and ADA/ABA 403.3

As Built Meas:	453	Quantity:	LF
Description:	Cross slope exceeds 2.0% (4.1% to 4.9%)		
As Built Desc:	4.1% cross slope		
Solution:	Demolish existing and construct new route		
Bar. Severity:	2 Recommended	Cost Estimate:	\$56,625.00
Implementation Priority:	4	Facility Function:	
Implementation Phase:		Implementation Date:	
Official Responsible:			
Notes:

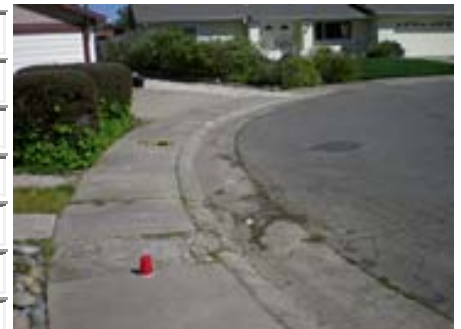
Field Date:	3/31/2011	Report Date:	3/31/2011	Barrier #:	6425A
Location:	Amsell Ct - North				
X Coordinate:	-121.2499				
Y Coordinate:	38.69862				
Barrier Area:	Sidewalks				
Barrier Type:	Cross Slope - Existing (3.1% to 4.0%)				
Code Ref:	CBC 1133B.7.1.3 and ADA/ABA 403.3

As Built Meas:	500	Quantity:	LF
Description:	Cross slope exceeds 2.0% (3.1% to 4.0%)		
As Built Desc:	4.0% cross slope		
Solution:	Demolish existing and construct new route		
Bar. Severity:	3 Hindrance	Cost Estimate:	\$62,500.00
Implementation Priority:	4	Facility Function:	
Implementation Phase:		Implementation Date:	
Official Responsible:

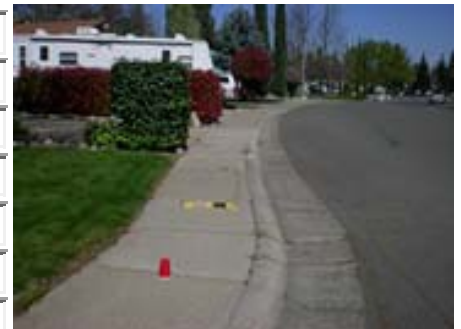
Field Date:	3/31/2011	Report Date:	3/31/2011	Barrier #:	6426
Location:	Menke Wy - West				
X Coordinate:	-121.2485				
Y Coordinate:	38.69916				
Barrier Area:	Sidewalks				
Barrier Type:	Cross Slope - Existing (3.1% to 4.0%)				
Code Ref:	CBC 1133B.7.1.3 and ADA/ABA 403.3

As Built Meas:	451	Quantity:	LF
Description:	Cross slope exceeds 2.0% (3.1% to 4.0%)		
As Built Desc:	3.5% cross slope		
Solution:	Demolish existing and construct new route		
Bar. Severity:	3 Hindrance	Cost Estimate:	\$56,375.00
Implementation Priority:	4	Facility Function:	
Implementation Phase:		Implementation Date:	
Official Responsible:			
Notes:

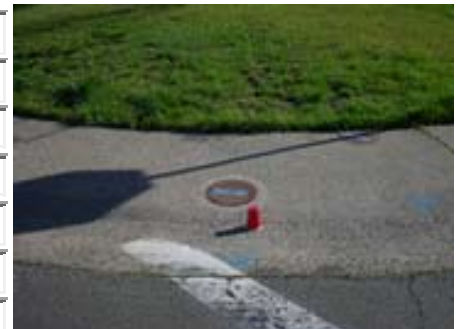
Field Date:	4/1/2011	Report Date:	4/1/2011	Barrier #:	6428
Location:	Old Ranch Rd and Jordell Ct - Corner B				
X Coordinate:	-121.25144				
Y Coordinate:	38.69964				
Barrier Area:	Curb Ramps				
Barrier Type:	No Curb Ramp - Depressed Existing Curb				
Code Ref:	CBC 1127B.5.1 and ADA/ABA 402.2

As Built Meas:	1	Quantity:	EACH
Description:	No compliant curb cut at corner (intersection)		
As Built Desc:	10.8% running slope at depressed area		
Solution:	Demolish existing and construct curb cut		
Bar. Severity:	1 Necessary	Cost Estimate:	\$2,500.00
Implementation Priority:	3	Facility Function:	
Implementation Phase:		Implementation Date:	
Official Responsible:

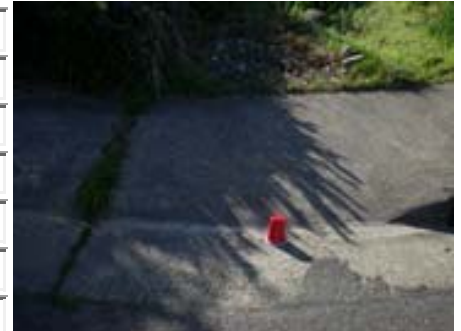
Field Date:	4/1/2011	Report Date:	4/1/2011	Barrier #:	6429
Location:	Old Ranch Rd and Jordell Ct - Corner C				
X Coordinate:	-121.25143				
Y Coordinate:	38.69954				
Barrier Area:	Curb Ramps				
Barrier Type:	No Curb Ramp - Depressed Existing Curb				
Code Ref:	CBC 1127B.5.1 and ADA/ABA 402.2

As Built Meas:	1	Quantity:	EACH
Description:	No compliant curb cut at corner (intersection)		
As Built Desc:	11.3% running slope at depressed area		
Solution:	Demolish existing and construct curb cut		
Bar. Severity:	1 Necessary	Cost Estimate:	\$2,500.00
Implementation Priority:	3	Facility Function:	
Implementation Phase:		Implementation Date:	
Official Responsible:			
Notes:	Two - way intersection corners B,C

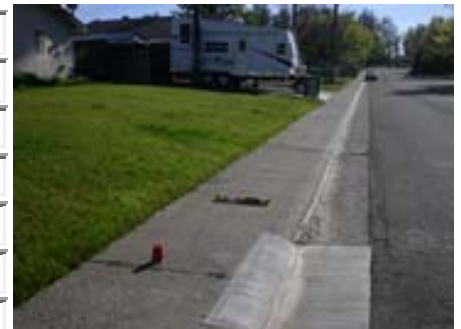
Field Date:	4/1/2011	Report Date:	4/1/2011	Barrier #:	6430
Location:	Jordell Ct - North				
X Coordinate:	-121.25139				
Y Coordinate:	38.69963				
Barrier Area:	Sidewalks				
Barrier Type:	Cross Slope - Existing (5.0% or more)				
Code Ref:	CBC 1133B.7.1.3 and ADA/ABA 403.3

As Built Meas:	614	Quantity:	LF
Description:	Cross slope exceeds 2.0% (5.0% or more)		
As Built Desc:	5.3% cross slope		
Solution:	Demolish existing and construct new route		
Bar. Severity:	1 Necessary	Cost Estimate:	\$76,750.00
Implementation Priority:	4	Facility Function:	
Implementation Phase:		Implementation Date:	
Official Responsible:			
Notes:

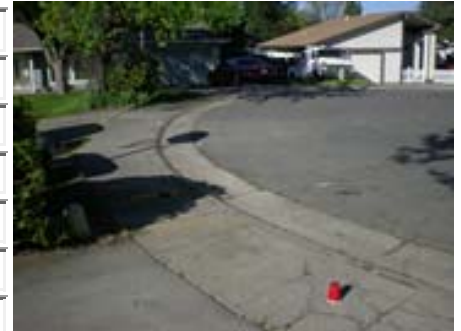
Field Date:	4/1/2011	Report Date:	4/1/2011	Barrier #:	6431
Location:	Jordell Ct - South				
X Coordinate:	-121.2494				
Y Coordinate:	38.69941				
Barrier Area:	Sidewalks				
Barrier Type:	Cross Slope - Existing (5.0% or more)				
Code Ref:	CBC 1133B.7.1.3 and ADA/ABA 403.3

As Built Meas:	346	Quantity:	LF
Description:	Cross slope exceeds 2.0% (5.0% or more)		
As Built Desc:	5.4% cross slope		
Solution:	Demolish existing and construct new route		
Bar. Severity:	1 Necessary	Cost Estimate:	\$43,250.00
Implementation Priority:	4	Facility Function:	
Implementation Phase:		Implementation Date:	
Official Responsible:

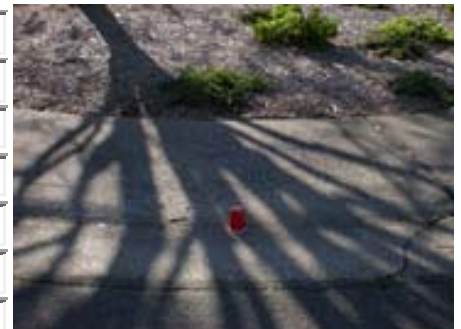
Field Date:	4/1/2011	Report Date:	4/1/2011	Barrier #:	6432
Location:	Jordell Ct and Jordell Ct - Corner C				
X Coordinate:	-121.25041				
Y Coordinate:	38.69955				
Barrier Area:	Curb Ramps				
Barrier Type:	No Curb Ramp - Depressed Existing Curb				
Code Ref:	CBC 1127B.5.1 and ADA/ABA 402.2

As Built Meas:	1	Quantity:	EACH
Description:	No compliant curb cut at corner (intersection)		
As Built Desc:	9.0% running slope at depressed area		
Solution:	Demolish existing and construct curb cut		
Bar. Severity:	1 Necessary	Cost Estimate:	\$2,500.00
Implementation Priority:	4	Facility Function:	
Implementation Phase:		Implementation Date:	
Official Responsible:
