DRAFT ADA TRANSITION PLAN UPDATE
NEIGHBORHOOD AREA 9 SONA
SEPTEMBER 20, 2011

CITY OF CITRUS HEIGHTS

The Sunrise Oaks Neighborhood Association (SONA)

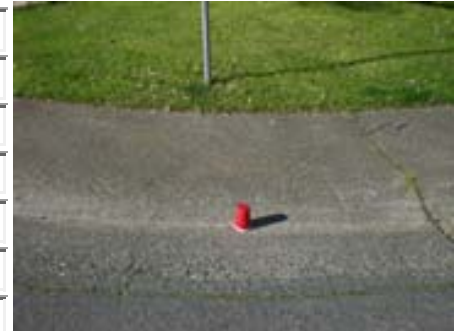
Field Date:	4/1/2011	Report Date:	4/1/2011	Barrier #:	6433
Location:	Jordell Ct and Jordell Ct - Corner D				
X Coordinate:	-121.25057				
Y Coordinate:	38.69958				
Barrier Area:	Curb Ramps				
Barrier Type:	No Curb Ramp - Depressed Existing Curb				
Code Ref:	CBC 1127B.5.1 and ADA/ABA 402.2

As Built Meas:	1	Quantity:	EACH
Description:	No compliant curb cut at corner (intersection)		
As Built Desc:	8.7% running slope at depressed area		
Solution:	Demolish existing and construct curb cut		
Bar. Severity:	1 Necessary	Cost Estimate:	\$2,500.00
Implementation Priority:	4	Facility Function:	
Implementation Phase:		Implementation Date:	
Official Responsible:			
Notes:	Two - way intersection corners C,D

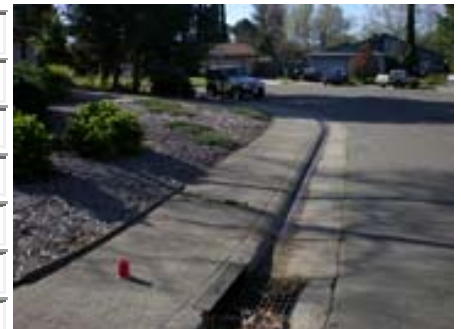
Field Date:	4/1/2011	Report Date:	4/1/2011	Barrier #:	6434
Location:	Jordell Ct - East				
X Coordinate:	-121.25039				
Y Coordinate:	38.69949				
Barrier Area:	Sidewalks				
Barrier Type:	Cross Slope - Existing (5.0% or more)				
Code Ref:	CBC 1133B.7.1.3 and ADA/ABA 403.3

As Built Meas:	194	Quantity:	LF
Description:	Cross slope exceeds 2.0% (5.0% or more)		
As Built Desc:	5.0% cross slope		
Solution:	Demolish existing and construct new route		
Bar. Severity:	1 Necessary	Cost Estimate:	\$24,250.00
Implementation Priority:	4	Facility Function:	
Implementation Phase:		Implementation Date:	
Official Responsible:			
Notes:

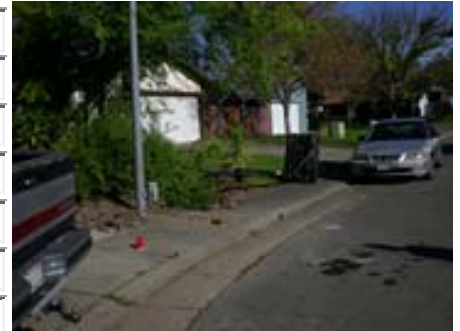
Field Date:	4/1/2011	Report Date:	4/1/2011	Barrier #:	6435
Location:	Jordell Ct - West				
X Coordinate:	-121.25058				
Y Coordinate:	38.69916				
Barrier Area:	Sidewalks				
Barrier Type:	Cross Slope - Existing (5.0% or more)				
Code Ref:	CBC 1133B.7.1.3 and ADA/ABA 403.3

As Built Meas:	194	Quantity:	LF
Description:	Cross slope exceeds 2.0% (5.0% or more)		
As Built Desc:	5.1% cross slope		
Solution:	Demolish existing and construct new route		
Bar. Severity:	1 Necessary	Cost Estimate:	\$24,250.00
Implementation Priority:	4	Facility Function:	
Implementation Phase:		Implementation Date:	
Official Responsible:			
Notes:

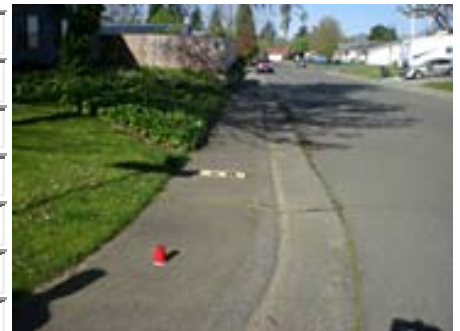
Field Date:	4/1/2011	Report Date:	4/1/2011	Barrier #:	6436
Location:	Jordell Ct - South				
X Coordinate:	-121.25067				
Y Coordinate:	38.69956				
Barrier Area:	Sidewalks				
Barrier Type:	Cross Slope - Existing (5.0% or more)				
Code Ref:	CBC 1133B.7.1.3 and ADA/ABA 403.3

As Built Meas:	228	Quantity:	LF
Description:	Cross slope exceeds 2.0% (5.0% or more)		
As Built Desc:	5.1% cross slope		
Solution:	Demolish existing and construct new route		
Bar. Severity:	1 Necessary	Cost Estimate:	\$28,500.00
Implementation Priority:	4	Facility Function:	
Implementation Phase:		Implementation Date:	
Official Responsible:			
Notes:

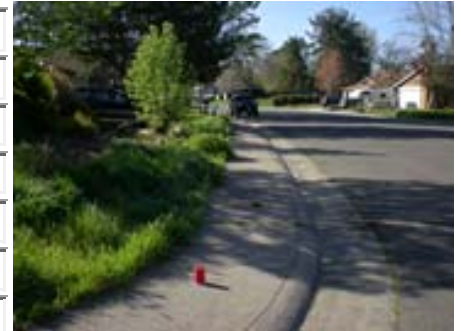
Field Date:	4/1/2011	Report Date:	4/1/2011	Barrier #:	6437
Location:	Old Ranch Rd - East				
X Coordinate:	-121.25143				
Y Coordinate:	38.69944				
Barrier Area:	Sidewalks				
Barrier Type:	Cross Slope - Existing (5.0% or more)				
Code Ref:	CBC 1133B.7.1.3 and ADA/ABA 403.3

As Built Meas:	1194	Quantity:	LF
Description:	Cross slope exceeds 2.0% (5.0% or more)		
As Built Desc:	5.1% cross slope		
Solution:	Demolish existing and construct new route		
Bar. Severity:	1 Necessary	Cost Estimate:	\$149,250.00
Implementation Priority:	3	Facility Function:	
Implementation Phase:		Implementation Date:	
Official Responsible:

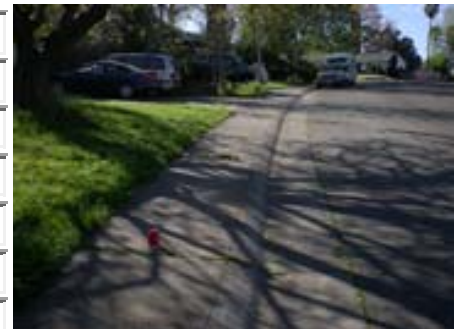
Field Date:	4/1/2011	Report Date:	4/1/2011	Barrier #:	6438
Location:	Old Ranch Rd - East				
X Coordinate:	-121.24902				
Y Coordinate:	38.69673				
Barrier Area:	Sidewalks				
Barrier Type:	Cross Slope - Existing (5.0% or more)				
Code Ref:	CBC 1133B.7.1.3 and ADA/ABA 403.3

As Built Meas:	216	Quantity:	LF
Description:	Cross slope exceeds 2.0% (5.0% or more)		
As Built Desc:	6.3% cross slope		
Solution:	Demolish existing and construct new route		
Bar. Severity:	1 Necessary	Cost Estimate:	\$27,000.00
Implementation Priority:	3	Facility Function:	
Implementation Phase:		Implementation Date:	
Official Responsible:

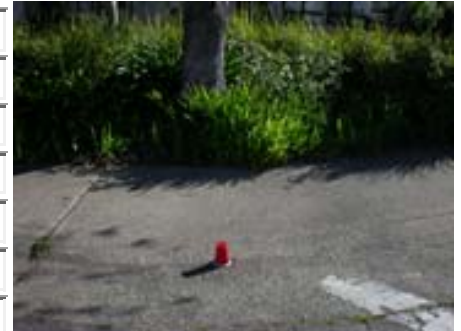
Field Date:	4/1/2011	Report Date:	4/1/2011	Barrier #:	6439
Location:	Old Ranch Rd and Mansfield Dr - Corner B				
X Coordinate:	-121.24891				
Y Coordinate:	38.69615				
Barrier Area:	Curb Ramps				
Barrier Type:	No Curb Ramp - Depressed Existing Curb				
Code Ref:	CBC 1127B.5.1 and ADA/ABA 402.2

As Built Meas:	1	Quantity:	EACH
Description:	No compliant curb cut at corner (intersection)		
As Built Desc:	10.4% running slope at depressed area		
Solution:	Demolish existing and construct curb cut		
Bar. Severity:	1 Necessary	Cost Estimate:	\$2,500.00
Implementation Priority:	3	Facility Function:	
Implementation Phase:		Implementation Date:	
Official Responsible:			
Notes:	Two - way intersection corners B,C

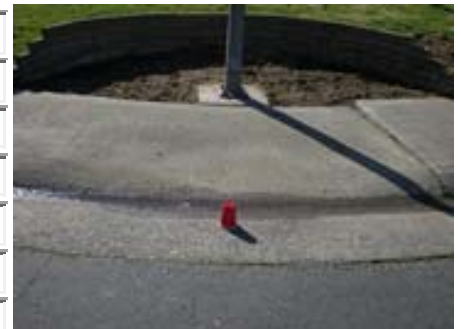
Field Date:	4/1/2011	Report Date:	4/1/2011	Barrier #:	6440
Location:	Old Ranch Rd and Mansfield Dr - Corner C				
X Coordinate:	-121.24892				
Y Coordinate:	38.69599				
Barrier Area:	Curb Ramps				
Barrier Type:	No Curb Ramp - Depressed Existing Curb				
Code Ref:	CBC 1127B.5.1 and ADA/ABA 402.2

As Built Meas:	1	Quantity:	EACH
Description:	No compliant curb cut at corner (intersection)		
As Built Desc:	11.9% running slope at depressed area		
Solution:	Demolish existing and construct curb cut		
Bar. Severity:	1 Necessary	Cost Estimate:	\$2,500.00
Implementation Priority:	3	Facility Function:	
Implementation Phase:		Implementation Date:	
Official Responsible:			
Notes:	Two - way intersection corners B,C

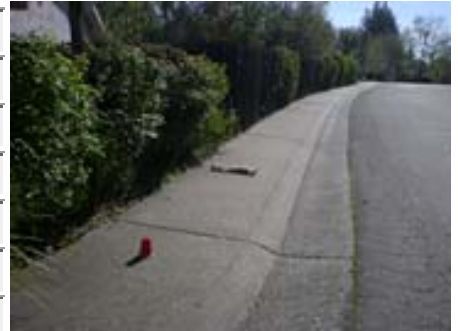
Field Date:	4/1/2011	Report Date:	4/1/2011	Barrier #:	6441
Location:	Mansfield Dr - North				
X Coordinate:	-121.24886				
Y Coordinate:	38.69611				
Barrier Area:	Sidewalks				
Barrier Type:	Cross Slope - Existing (5.0% or more)				
Code Ref:	CBC 1133B.7.1.3 and ADA/ABA 403.3

As Built Meas:	210	Quantity:	LF
Description:	Cross slope exceeds 2.0% (5.0% or more)		
As Built Desc:	5.0% cross slope		
Solution:	Demolish existing and construct new route		
Bar. Severity:	1 Necessary	Cost Estimate:	\$26,250.00
Implementation Priority:	4	Facility Function:	
Implementation Phase:		Implementation Date:	
Official Responsible:

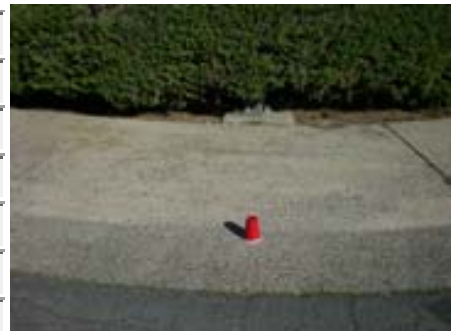
Field Date:	4/1/2011	Report Date:	4/1/2011	Barrier #:	6442
Location:	Mansfield Dr and Mansfield Dr Ct - Corner A				
X Coordinate:	-121.24818				
Y Coordinate:	38.69599				
Barrier Area:	Curb Ramps				
Barrier Type:	No Curb Ramp - Depressed Existing Curb				
Code Ref:	CBC 1127B.5.1 and ADA/ABA 402.2

As Built Meas:	1	Quantity:	EACH
Description:	No compliant curb cut at corner (intersection)		
As Built Desc:	10.7% running slope at depressed area		
Solution:	Demolish existing and construct curb cut		
Bar. Severity:	1 Necessary	Cost Estimate:	\$2,500.00
Implementation Priority:	4	Facility Function:	
Implementation Phase:		Implementation Date:	
Official Responsible:

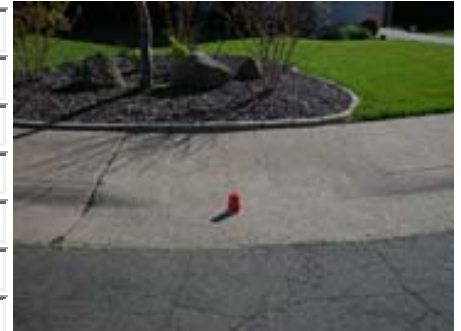
Field Date:	4/1/2011	Report Date:	4/1/2011	Barrier #:	6443
Location:	Mansfield Dr and Mansfield Dr Ct - Corner B				
X Coordinate:	-121.24798				
Y Coordinate:	38.69594				
Barrier Area:	Curb Ramps				
Barrier Type:	No Curb Ramp - Depressed Existing Curb				
Code Ref:	CBC 1127B.5.1 and ADA/ABA 402.2

As Built Meas:	1	Quantity:	EACH
Description:	No compliant curb cut at corner (intersection)		
As Built Desc:	9.7% running slope at depressed area		
Solution:	Demolish existing and construct curb cut		
Bar. Severity:	1 Necessary	Cost Estimate:	\$2,500.00
Implementation Priority:	4	Facility Function:	
Implementation Phase:		Implementation Date:	
Official Responsible:			
Notes:	Two - way intersection corners A,B

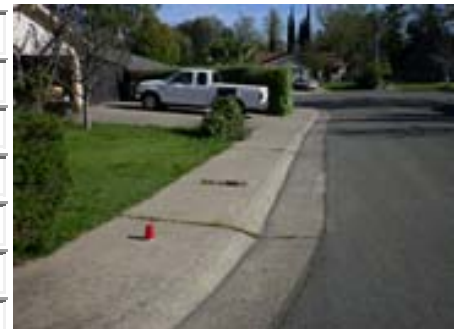
Field Date:	4/1/2011	Report Date:	4/1/2011	Barrier #:	6444A
Location:	Mansfield Dr Ct - West				
X Coordinate:	-121.24816				
Y Coordinate:	38.69603				
Barrier Area:	Sidewalks				
Barrier Type:	Cross Slope - Existing (4.1% to 4.9%)				
Code Ref:	CBC 1133B.7.1.3 and ADA/ABA 403.3

As Built Meas:	236	Quantity:	LF
Description:	Cross slope exceeds 2.0% (4.1% to 4.9%)		
As Built Desc:	4.2% cross slope		
Solution:	Demolish existing and construct new route		
Bar. Severity:	2 Recommended	Cost Estimate:	\$29,500.00
Implementation Priority:	4	Facility Function:	
Implementation Phase:		Implementation Date:	
Official Responsible:			
Notes:

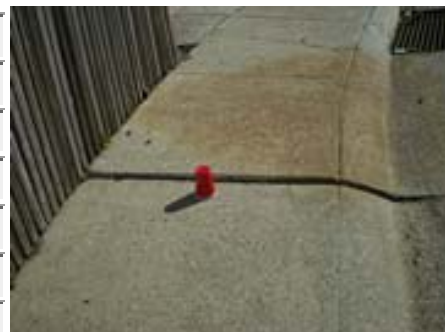
Field Date:	4/1/2011	Report Date:	4/1/2011	Barrier #:	6444B
Location:	Mansfield Dr Ct - West				
X Coordinate:	-121.24792				
Y Coordinate:	38.69644				
Barrier Area:	Sidewalks				
Barrier Type:	Abrupt Change in Level - > 1/2"				
Code Ref:	CBC 1133B.7.1 and ADA/ABA 303.3

As Built Meas:	4	Quantity:	LF
Description:	Change in level greater than 1/2"		
As Built Desc:	1" lip in sidewalk surface		
Solution:	Grind or repair sidewalk to remove trip hazard		
Bar. Severity:	1 Necessary	Cost Estimate:	\$1,000.00
Implementation Priority:	4	Facility Function:	
Implementation Phase:		Implementation Date:	
Official Responsible:			
Notes:

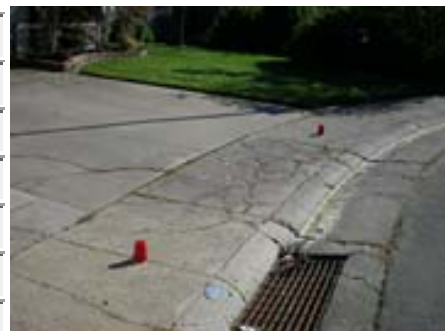
Field Date:	4/1/2011	Report Date:	4/1/2011	Barrier #:	6444C
Location:	Mansfield Dr Ct - West				
X Coordinate:	-121.24786				
Y Coordinate:	38.69646				
Barrier Area:	Sidewalks				
Barrier Type:	Surface Condition - Damaged				
Code Ref:	CBC 1133B.7.1 and ADA/ABA 302.1

As Built Meas:	8	Quantity:	LF
Description:	Surface is not firm and stable (cracked, broken or loose soil, etc.)		
As Built Desc:	Cracked concrete		
Solution:	Repair surface to make firm and stable		
Bar. Severity:	1 Necessary	Cost Estimate:	\$1,000.00
Implementation Priority:	4	Facility Function:	
Implementation Phase:		Implementation Date:	
Official Responsible:			
Notes:

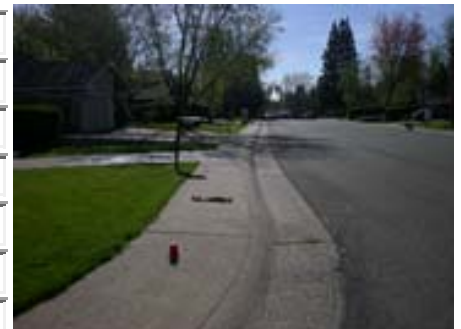
Field Date:	4/1/2011	Report Date:	4/1/2011	Barrier #:	6446A
Location:	Mansfield Dr - North				
X Coordinate:	-121.24802				
Y Coordinate:	38.6959				
Barrier Area:	Sidewalks				
Barrier Type:	Cross Slope - Existing (5.0% or more)				
Code Ref:	CBC 1133B.7.1.3 and ADA/ABA 403.3

As Built Meas:	578	Quantity:	LF
Description:	Cross slope exceeds 2.0% (5.0% or more)		
As Built Desc:	5.9% cross slope		
Solution:	Demolish existing and construct new route		
Bar. Severity:	1 Necessary	Cost Estimate:	\$72,250.00
Implementation Priority:	4	Facility Function:	
Implementation Phase:		Implementation Date:	
Official Responsible:

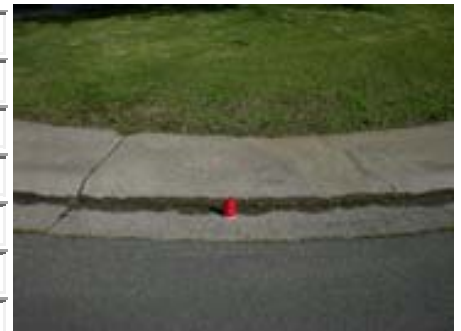
Barrier Type: No Curb Ramp - Depressed Existing Curb

Description: No compliant curb cut at corner (intersection)

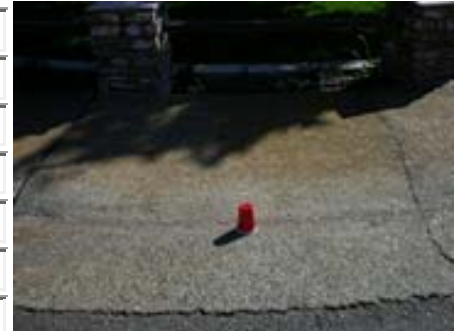
Field Date:	4/1/2011	Report Date:	4/1/2011	Barrier #:	6448
Location:	Mansfield Dr and Cranford Wy - Corner B				
X Coordinate:	-121.24613				
Y Coordinate:	38.69508				
Barrier Area:	Curb Ramps				
Barrier Type:	No Curb Ramp - Depressed Existing Curb				
Code Ref:	CBC 1127B.5.1 and ADA/ABA 402.2

As Built Meas:	1	Quantity:	EACH
Description:	No compliant curb cut at corner (intersection)		
As Built Desc:	7.9% running slope at depressed area		
Solution:	Demolish existing and construct curb cut		
Bar. Severity:	1 Necessary	Cost Estimate:	\$2,500.00
Implementation Priority:	4	Facility Function:	
Implementation Phase:		Implementation Date:	
Official Responsible:

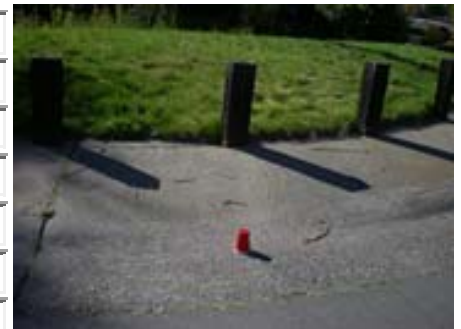
Field Date:	4/1/2011	Report Date:	4/1/2011	Barrier #:	6449
Location:	Mansfield Dr and Cranford Wy - Corner C				
X Coordinate:	-121.24616				
Y Coordinate:	38.69492				
Barrier Area:	Curb Ramps				
Barrier Type:	No Curb Ramp - Depressed Existing Curb				
Code Ref:	CBC 1127B.5.1 and ADA/ABA 402.2

As Built Meas:	1	Quantity:	EACH
Description:	No compliant curb cut at corner (intersection)		
As Built Desc:	11.2% running slope at depressed area		
Solution:	Demolish existing and construct curb cut		
Bar. Severity:	1 Necessary	Cost Estimate:	\$2,500.00
Implementation Priority:	4	Facility Function:	
Implementation Phase:		Implementation Date:	
Official Responsible:

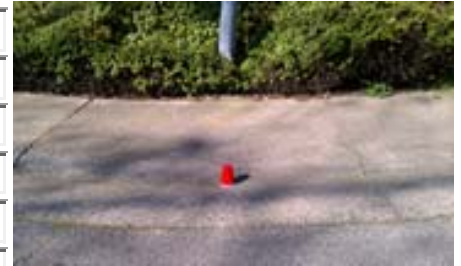
Field Date:	4/1/2011	Report Date:	4/1/2011	Barrier #:	6450
Location:	Mansfield Dr and Cranford Wy - Corner D				
X Coordinate:	-121.24635				
Y Coordinate:	38.69497				
Barrier Area:	Curb Ramps				
Barrier Type:	No Curb Ramp - Depressed Existing Curb				
Code Ref:	CBC 1127B.5.1 and ADA/ABA 402.2

As Built Meas:	1	Quantity:	EACH
Description:	No compliant curb cut at corner (intersection)		
As Built Desc:	8.3% running slope at depressed area		
Solution:	Demolish existing and construct curb cut		
Bar. Severity:	1 Necessary	Cost Estimate:	\$2,500.00
Implementation Priority:	4	Facility Function:	
Implementation Phase:		Implementation Date:	
Official Responsible:			
Notes:	Four - way intersection corners A, B, C, D

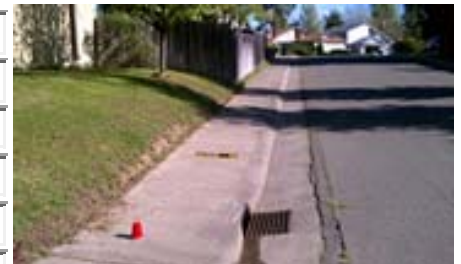
Field Date:	4/1/2011	Report Date:	4/1/2011	Barrier #:	6451
Location:	Cranford Wy - West				
X Coordinate:	-121.24625				
Y Coordinate:	38.69517				
Barrier Area:	Sidewalks				
Barrier Type:	Cross Slope - Existing (3.1% to 4.0%)				
Code Ref:	CBC 1133B.7.1.3 and ADA/ABA 403.3

As Built Meas:	415	Quantity:	LF
Description:	Cross slope exceeds 2.0% (3.1% to 4.0%)		
As Built Desc:	3.7% cross slope		
Solution:	Demolish existing and construct new route		
Bar. Severity:	3 Hindrance	Cost Estimate:	\$51,875.00
Implementation Priority:	4	Facility Function:	
Implementation Phase:		Implementation Date:	
Official Responsible:			
Notes:

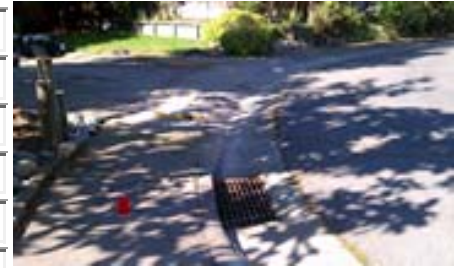
Barrier Type: Cross Slope - Existing (5.0% or more)

Description: Cross slope exceeds 2.0% (5.0% or more)

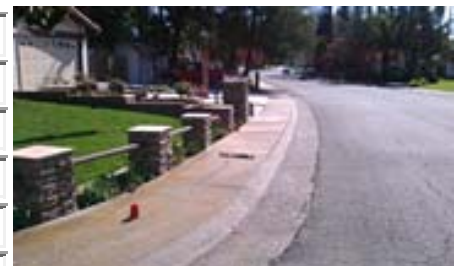
Barrier Type: Cross Slope - Existing (4.1% to 4.9%)

Description: Cross slope exceeds 2.0% (4.1% to 4.9%)

Bar. Severity: 2 Recommended Cost Estimate: \$57,125.00 Status:

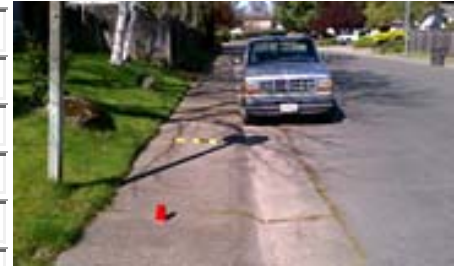
Field Date:	4/1/2011	Report Date:	4/1/2011	Barrier #:	6454
Location:	Mansfield Dr - South				
X Coordinate:	-121.24461				
Y Coordinate:	38.69487				
Barrier Area:	Sidewalks				
Barrier Type:	Cross Slope - Existing (5.0% or more)				
Code Ref:	CBC 1133B.7.1.3 and ADA/ABA 403.3

As Built Meas:	235	Quantity:	LF
Description:	Cross slope exceeds 2.0% (5.0% or more)		
As Built Desc:	5.0% cross slope		
Solution:	Demolish existing and construct new route		
Bar. Severity:	1 Necessary	Cost Estimate:	\$29,375.00
Implementation Priority:	4	Facility Function:	
Implementation Phase:		Implementation Date:	
Official Responsible:

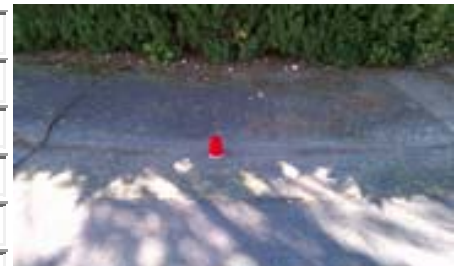
Field Date:	4/1/2011	Report Date:	4/1/2011	Barrier #:	6455
Location:	Mansfield Dr and Jenner Ct - Corner C				
X Coordinate:	-121.24534				
Y Coordinate:	38.69492				
Barrier Area:	Curb Ramps				
Barrier Type:	No Curb Ramp - Depressed Existing Curb				
Code Ref:	CBC 1127B.5.1 and ADA/ABA 402.2

As Built Meas:	1	Quantity:	EACH
Description:	No compliant curb cut at corner (intersection)		
As Built Desc:	9.2% running slope at depressed area		
Solution:	Demolish existing and construct curb cut		
Bar. Severity:	1 Necessary	Cost Estimate:	\$2,500.00
Implementation Priority:	4	Facility Function:	
Implementation Phase:		Implementation Date:	
Official Responsible:

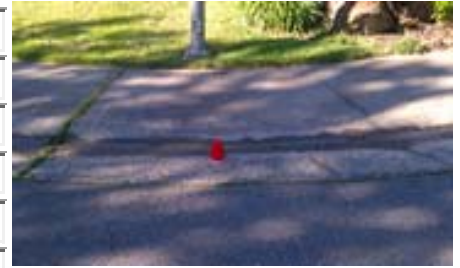
Field Date:	4/1/2011	Report Date:	4/1/2011	Barrier #:	6456
Location:	Mansfield Dr and Jenner Ct - Corner D				
X Coordinate:	-121.24551				
Y Coordinate:	38.6949				
Barrier Area:	Curb Ramps				
Barrier Type:	No Curb Ramp - Depressed Existing Curb				
Code Ref:	CBC 1127B.5.1 and ADA/ABA 402.2

As Built Meas:	1	Quantity:	EACH
Description:	No compliant curb cut at corner (intersection)		
As Built Desc:	9.2% running slope at depressed area		
Solution:	Demolish existing and construct curb cut		
Bar. Severity:	1 Necessary	Cost Estimate:	\$2,500.00
Implementation Priority:	4	Facility Function:	
Implementation Phase:		Implementation Date:	
Official Responsible:			
Notes:	Two - way intersection corners C,D

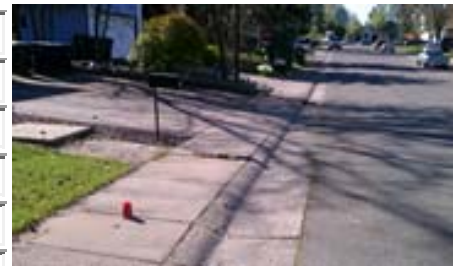
Field Date:	4/1/2011	Report Date:	4/1/2011	Barrier #:	6457A
Location:	Jenner Ct - East				
X Coordinate:	-121.24536				
Y Coordinate:	38.69478				
Barrier Area:	Sidewalks				
Barrier Type:	Cross Slope - Existing (3.1% to 4.0%)				
Code Ref:	CBC 1133B.7.1.3 and ADA/ABA 403.3

As Built Meas:	502	Quantity:	LF
Description:	Cross slope exceeds 2.0% (3.1% to 4.0%)		
As Built Desc:	4.0% cross slope		
Solution:	Demolish existing and construct new route		
Bar. Severity:	3 Hindrance	Cost Estimate:	\$62,750.00
Implementation Priority:	4	Facility Function:	
Implementation Phase:		Implementation Date:	
Official Responsible:			
Notes:

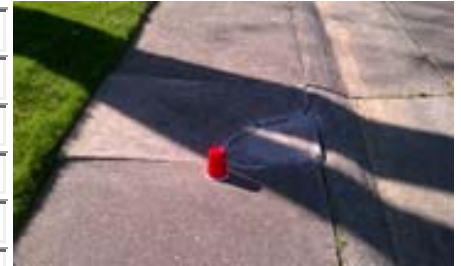
Field Date:	4/1/2011	Report Date:	4/1/2011	Barrier #:	6457B
Location:	Jenner Ct - East				
X Coordinate:	-121.24539				
Y Coordinate:	38.6935				
Barrier Area:	Sidewalks				
Barrier Type:	Surface Condition - Damaged				
Code Ref:	CBC 1133B.7.1 and ADA/ABA 302.1

As Built Meas:	4	Quantity:	LF
Description:	Surface is not firm and stable (cracked, broken or loose soil, etc.)		
As Built Desc:	Cracked concrete		
Solution:	Repair surface to make firm and stable		
Bar. Severity:	1 Necessary	Cost Estimate:	\$500.00
Implementation Priority:	4	Facility Function:	
Implementation Phase:		Implementation Date:	
Official Responsible:			
Notes:

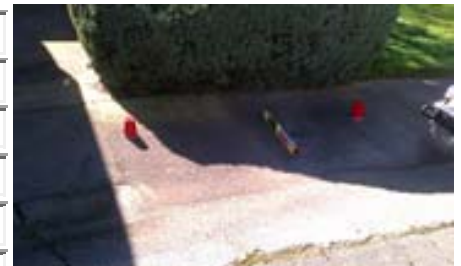
Field Date:	4/1/2011	Report Date:	4/1/2011	Barrier #:	6457C
Location:	Jenner Ct - East				
X Coordinate:	-121.24548				
Y Coordinate:	38.69346				
Barrier Area:	Sidewalks				
Barrier Type:	Elbow in Sidewalk - Cross Slope (5.0% or more)				
Code Ref:	CBC 1133B.7.1.3 and ADA/ABA 403.3

As Built Meas:	6	Quantity:	LF
Description:	Cross slope at elbow exceeds 2.0% (5.0% or more)		
As Built Desc:	9.8% cross slope		
Solution:	Demolish existing and construct new sidewalk without curb ramp		
Bar. Severity:	1 Necessary	Cost Estimate:	\$750.00
Implementation Priority:	4	Facility Function:	
Implementation Phase:		Implementation Date:	
Official Responsible:			
Notes:

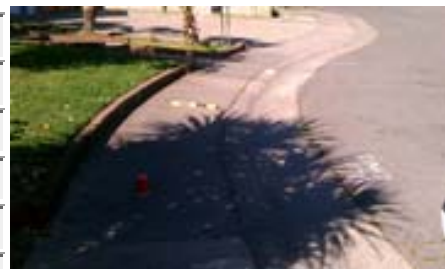
Field Date:	4/1/2011	Report Date:	4/1/2011	Barrier #:	6458
Location:	Jenner Ct - South				
X Coordinate:	-121.246				
Y Coordinate:	38.69361				
Barrier Area:	Sidewalks				
Barrier Type:	Cross Slope - Existing (3.1% to 4.0%)				
Code Ref:	CBC 1133B.7.1.3 and ADA/ABA 403.3

As Built Meas:	178	Quantity:	LF
Description:	Cross slope exceeds 2.0% (3.1% to 4.0%)		
As Built Desc:	3.2% cross slope		
Solution:	Demolish existing and construct new route		
Bar. Severity:	3 Hindrance	Cost Estimate:	\$22,250.00
Implementation Priority:	4	Facility Function:	
Implementation Phase:		Implementation Date:	
Official Responsible:			
Notes:

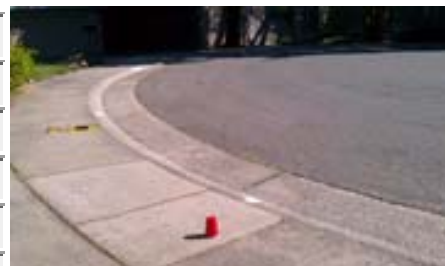
Field Date:	4/1/2011	Report Date:	4/1/2011	Barrier #:	6459
Location:	Jenner Ct - North				
X Coordinate:	-121.246				
Y Coordinate:	38.69358				
Barrier Area:	Sidewalks				
Barrier Type:	Cross Slope - Existing (5.0% or more)				
Code Ref:	CBC 1133B.7.1.3 and ADA/ABA 403.3

As Built Meas:	180	Quantity:	LF
Description:	Cross slope exceeds 2.0% (5.0% or more)		
As Built Desc:	5.6% cross slope		
Solution:	Demolish existing and construct new route		
Bar. Severity:	1 Necessary	Cost Estimate:	\$22,500.00
Implementation Priority:	4	Facility Function:	
Implementation Phase:		Implementation Date:	
Official Responsible:			
Notes:

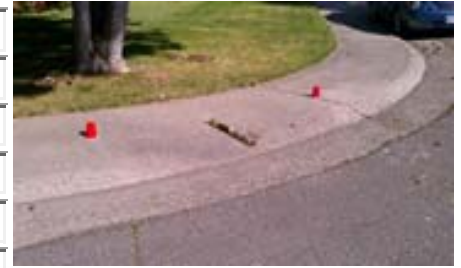
Field Date:	4/1/2011	Report Date:	4/1/2011	Barrier #:	6460
Location:	Jenner Ct - North				
X Coordinate:	-121.24557				
Y Coordinate:	38.69357				
Barrier Area:	Sidewalks				
Barrier Type:	Elbow in Sidewalk - Cross Slope (5.0% or more)				
Code Ref:	CBC 1133B.7.1.3 and ADA/ABA 403.3

As Built Meas:	6	Quantity:	LF
Description:	Cross slope at elbow exceeds 2.0% (5.0% or more)		
As Built Desc:	11.5% cross slope		
Solution:	Demolish existing and construct new sidewalk without curb ramp		
Bar. Severity:	1 Necessary	Cost Estimate:	\$750.00
Implementation Priority:	4	Facility Function:	
Implementation Phase:		Implementation Date:	
Official Responsible:

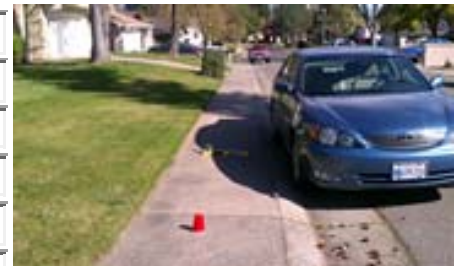
Field Date:	4/1/2011	Report Date:	4/1/2011	Barrier #:	6461
Location:	Jenner Ct - North				
X Coordinate:	-121.24551				
Y Coordinate:	38.6937				
Barrier Area:	Sidewalks				
Barrier Type:	Cross Slope - Existing (5.0% or more)				
Code Ref:	CBC 1133B.7.1.3 and ADA/ABA 403.3

As Built Meas:	453	Quantity:	LF
Description:	Cross slope exceeds 2.0% (5.0% or more)		
As Built Desc:	5.7% cross slope		
Solution:	Demolish existing and construct new route		
Bar. Severity:	1 Necessary	Cost Estimate:	\$56,625.00
Implementation Priority:	4	Facility Function:	
Implementation Phase:		Implementation Date:	
Official Responsible:

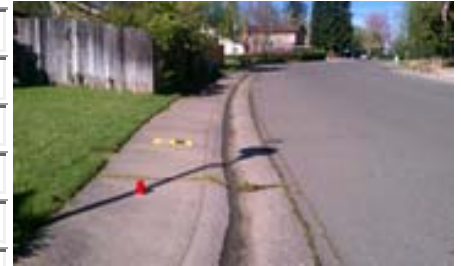
Field Date:	4/1/2011	Report Date:	4/1/2011	Barrier #:	6462
Location:	Mansfield Dr - South				
X Coordinate:	-121.24562				
Y Coordinate:	38.69491				
Barrier Area:	Sidewalks				
Barrier Type:	Cross Slope - Existing (5.0% or more)				
Code Ref:	CBC 1133B.7.1.3 and ADA/ABA 403.3

As Built Meas:	639	Quantity:	LF
Description:	Cross slope exceeds 2.0% (5.0% or more)		
As Built Desc:	4.2% cross slope		
Solution:	Demolish existing and construct new route		
Bar. Severity:	1 Necessary	Cost Estimate:	\$79,875.00
Implementation Priority:	4	Facility Function:	
Implementation Phase:		Implementation Date:	
Official Responsible:

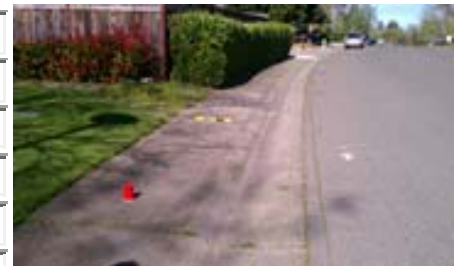
Field Date:	4/1/2011	Report Date:	4/1/2011	Barrier #:	6463
Location:	Mansfield Dr - South				
X Coordinate:	-121.24644				
Y Coordinate:	38.69499				
Barrier Area:	Sidewalks				
Barrier Type:	Cross Slope - Existing (4.1% to 4.9%)				
Code Ref:	CBC 1133B.7.1.3 and ADA/ABA 403.3

As Built Meas:	826	Quantity:	LF
Description:	Cross slope exceeds 2.0% (4.1% to 4.9%)		
As Built Desc:	4.5% cross slope		
Solution:	Demolish existing and construct new route		
Bar. Severity:	2 Recommended	Cost Estimate:	\$103,250.00
Implementation Priority:	4	Facility Function:	
Implementation Phase:		Implementation Date:	
Official Responsible:

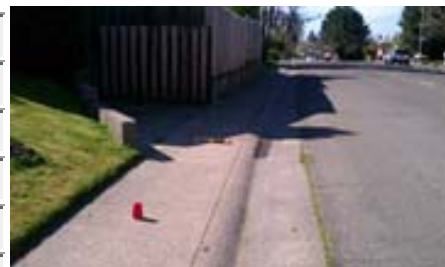
Field Date:	4/1/2011	Report Date:	4/1/2011	Barrier #:	6464
Location:	Old Ranch Rd - East				
X Coordinate:	-121.24897				
Y Coordinate:	38.69593				
Barrier Area:	Sidewalks				
Barrier Type:	Cross Slope - Existing (4.1% to 4.9%)				
Code Ref:	CBC 1133B.7.1.3 and ADA/ABA 403.3

As Built Meas:	205	Quantity:	LF
Description:	Cross slope exceeds 2.0% (4.1% to 4.9%)		
As Built Desc:	4.3% cross slope		
Solution:	Demolish existing and construct new route		
Bar. Severity:	2 Recommended	Cost Estimate:	\$25,625.00
Implementation Priority:	3	Facility Function:	
Implementation Phase:		Implementation Date:	
Official Responsible:			
Notes:

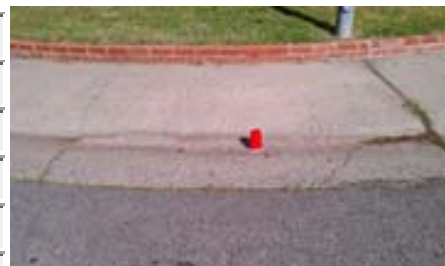
Field Date:	4/1/2011	Report Date:	4/1/2011	Barrier #:	6465
Location:	Old Ranch Rd and Kingsmill Wy - Corner A				
X Coordinate:	-121.24928				
Y Coordinate:	38.69547				
Barrier Area:	Curb Ramps				
Barrier Type:	No Curb Ramp - Depressed Existing Curb				
Code Ref:	CBC 1127B.5.1 and ADA/ABA 402.2

As Built Meas:	1	Quantity:	EACH
Description:	No compliant curb cut at corner (intersection)		
As Built Desc:	10.5% running slope at depressed area		
Solution:	Demolish existing and construct curb cut		
Bar. Severity:	1 Necessary	Cost Estimate:	\$2,500.00
Implementation Priority:	3	Facility Function:	
Implementation Phase:		Implementation Date:	
Official Responsible:			
Notes:	Four - way intersection corners A, B, C, D

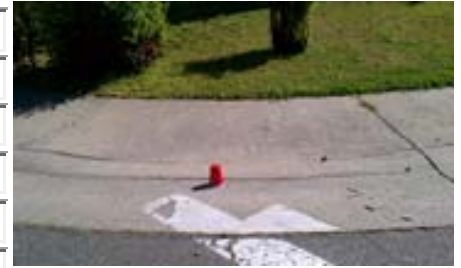
Field Date:	4/1/2011	Report Date:	4/1/2011	Barrier #:	6466
Location:	Old Ranch Rd and Kingsmill Wy - Corner B				
X Coordinate:	-121.24911				
Y Coordinate:	38.69543				
Barrier Area:	Curb Ramps				
Barrier Type:	No Curb Ramp - Depressed Existing Curb				
Code Ref:	CBC 1127B.5.1 and ADA/ABA 402.2

As Built Meas:	1	Quantity:	EACH
Description:	No compliant curb cut at corner (intersection)		
As Built Desc:	7.5% running slope at depressed area		
Solution:	Demolish existing and construct curb cut		
Bar. Severity:	1 Necessary	Cost Estimate:	\$2,500.00
Implementation Priority:	3	Facility Function:	
Implementation Phase:		Implementation Date:	
Official Responsible:			
Notes:	Four - way intersection corners A, B, C, D

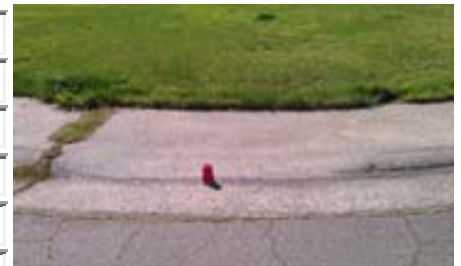
Field Date:	4/1/2011	Report Date:	4/1/2011	Barrier #:	6467
Location:	Old Ranch Rd and Kingsmill Wy - Corner C				
X Coordinate:	-121.24911				
Y Coordinate:	38.69529				
Barrier Area:	Curb Ramps				
Barrier Type:	No Curb Ramp - Depressed Existing Curb				
Code Ref:	CBC 1127B.5.1 and ADA/ABA 402.2

As Built Meas:	1	Quantity:	EACH
Description:	No compliant curb cut at corner (intersection)		
As Built Desc:	11.5% running slope at depressed area		
Solution:	Demolish existing and construct curb cut		
Bar. Severity:	1 Necessary	Cost Estimate:	\$2,500.00
Implementation Priority:	3	Facility Function:	
Implementation Phase:		Implementation Date:	
Official Responsible:			
Notes:	Four - way intersection corners A, B, C, D

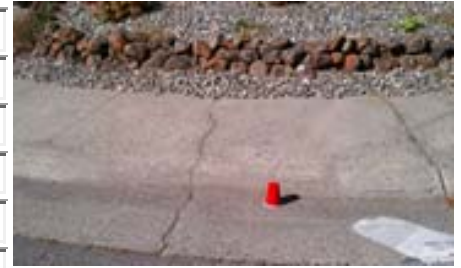
Field Date:	4/1/2011	Report Date:	4/1/2011	Barrier #:	6468
Location:	Old Ranch Rd and Kingsmill Wy - Corner D				
X Coordinate:	-121.24932				
Y Coordinate:	38.69533				
Barrier Area:	Curb Ramps				
Barrier Type:	No Curb Ramp - Depressed Existing Curb				
Code Ref:	CBC 1127B.5.1 and ADA/ABA 402.2

As Built Meas:	1	Quantity:	EACH
Description:	No compliant curb cut at corner (intersection)		
As Built Desc:	13.2% running slope at depressed area		
Solution:	Demolish existing and construct curb cut		
Bar. Severity:	1 Necessary	Cost Estimate:	\$2,500.00
Implementation Priority:	3	Facility Function:	
Implementation Phase:		Implementation Date:	
Official Responsible:			
Notes:	Four - way intersection corners A, B, C, D

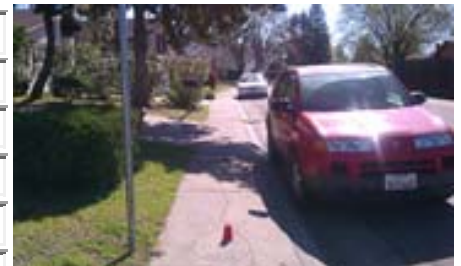
Field Date:	4/1/2011	Report Date:	4/1/2011	Barrier #:	6469
Location:	Kingsmill Wy - North				
X Coordinate:	-121.24901				
Y Coordinate:	38.69539				
Barrier Area:	Sidewalks				
Barrier Type:	Cross Slope - Existing (5.0% or more)				
Code Ref:	CBC 1133B.7.1.3 and ADA/ABA 403.3

As Built Meas:	857	Quantity:	LF
Description:	Cross slope exceeds 2.0% (5.0% or more)		
As Built Desc:	5.2% cross slope		
Solution:	Demolish existing and construct new route		
Bar. Severity:	1 Necessary	Cost Estimate:	\$107,125.00
Implementation Priority:	4	Facility Function:	
Implementation Phase:		Implementation Date:	
Official Responsible:			
Notes:

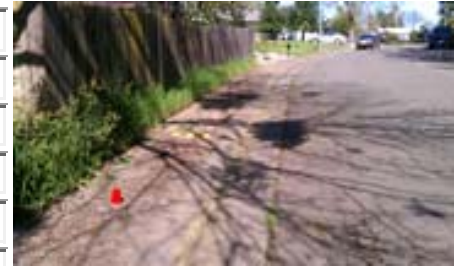
Barrier Type: Cross Slope - Existing (5.0% or more)

As Built Meas: 890 Quantity: LF

Description: Cross slope exceeds 2.0% (5.0% or more)

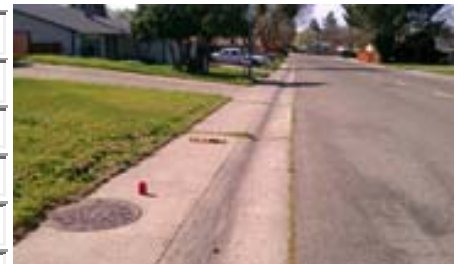
Barrier Type: Cross Slope - Existing (4.1% to 4.9%)

As Built Meas: 607 Quantity: LF

Description: Cross slope exceeds 2.0% (4.1% to 4.9%)

Bar. Severity: 2 Recommended Cost Estimate: \$75,875.00 Status:

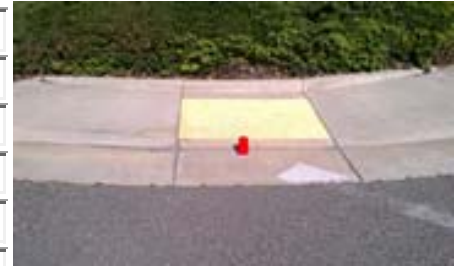
Field Date:	4/1/2011	Report Date:	4/1/2011	Barrier #:	6472
Location:	Old Ranch Rd and Cranford Wy - Corner A				
X Coordinate:	-121.24977				
Y Coordinate:	38.69362				
Barrier Area:	Curb Ramps				
Barrier Type:	12" Grooves - Existing (3.1% to 4.0%)				
Code Ref:	CBC 1127B.5.6

As Built Meas:	1	Quantity:	EACH
Description:	12" grooves at top of curb ramp are not level (3.1% to 4.0%)		
As Built Desc:	3.8% at 12" grooves		
Solution:	Demolish existing and construct new curb ramp		
Bar. Severity:	3 Hindrance	Cost Estimate:	\$2,500.00
Implementation Priority:	3	Facility Function:	
Implementation Phase:		Implementation Date:	
Official Responsible:

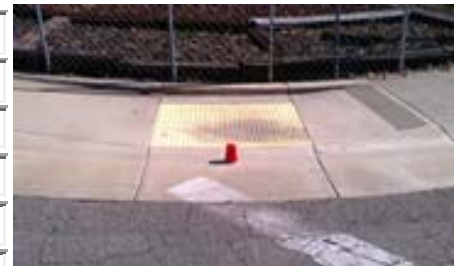
Field Date:	4/1/2011	Report Date:	4/1/2011	Barrier #:	6473
Location:	Old Ranch Rd and Cranford Wy - Corner B				
X Coordinate:	-121.24957				
Y Coordinate:	38.69362				
Barrier Area:	Curb Ramps				
Barrier Type:	12" Grooves - Existing (>5.0%)				
Code Ref:	CBC 1127B.5.6

As Built Meas:	1	Quantity:	EACH
Description:	12" grooves at top of curb ramp are not level (>5.0%)		
As Built Desc:	7.3% at 12" grooves		
Solution:	Demolish existing and construct new curb ramp		
Bar. Severity:	1 Necessary	Cost Estimate:	\$2,500.00
Implementation Priority:	3	Facility Function:	
Implementation Phase:		Implementation Date:	
Official Responsible:

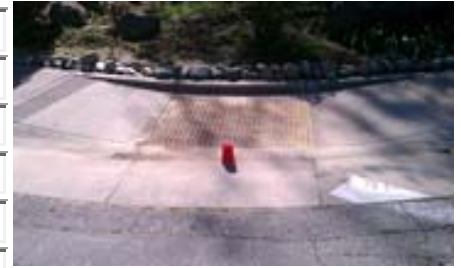
Field Date:	4/1/2011	Report Date:	4/1/2011	Barrier #:	6474
Location:	Old Ranch Rd and Cranford Wy - Corner C				
X Coordinate:	-121.24959				
Y Coordinate:	38.69353				
Barrier Area:	Curb Ramps				
Barrier Type:	12" Grooves - Existing (3.1% to 4.0%)				
Code Ref:	CBC 1127B.5.6

As Built Meas:	1	Quantity:	EACH
Description:	12" grooves at top of curb ramp are not level (3.1% to 4.0%)		
As Built Desc:	3.6% at 12" grooves		
Solution:	Demolish existing and construct new curb ramp		
Bar. Severity:	3 Hindrance	Cost Estimate:	\$2,500.00
Implementation Priority:	3	Facility Function:	
Implementation Phase:		Implementation Date:	
Official Responsible:

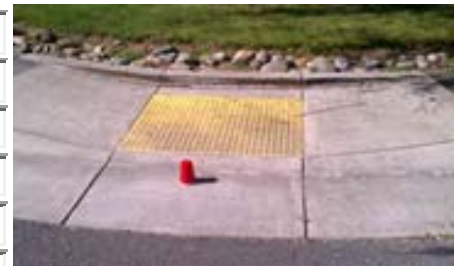
Field Date:	4/1/2011	Report Date:	4/1/2011	Barrier #:	6475
Location:	Old Ranch Rd and Cranford Wy - Corner D				
X Coordinate:	-121.24977				
Y Coordinate:	38.69349				
Barrier Area:	Curb Ramps				
Barrier Type:	12" Grooves - Existing (>5.0%)				
Code Ref:	CBC 1127B.5.6

As Built Meas:	1	Quantity:	EACH
Description:	12" grooves at top of curb ramp are not level (>5.0%)		
As Built Desc:	5.9% at 12" grooves		
Solution:	Demolish existing and construct new curb ramp		
Bar. Severity:	1 Necessary	Cost Estimate:	\$2,500.00
Implementation Priority:	3	Facility Function:	
Implementation Phase:		Implementation Date:	
Official Responsible:

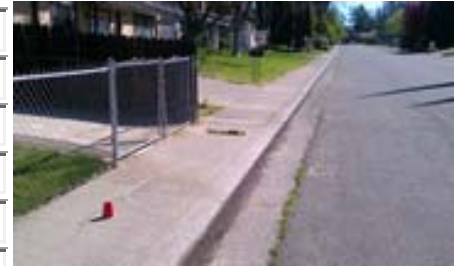
Field Date:	4/1/2011	Report Date:	4/1/2011	Barrier #:	6476
Location:	Cranford Wy - North				
X Coordinate:	-121.24937				
Y Coordinate:	38.69362				
Barrier Area:	Sidewalks				
Barrier Type:	Cross Slope - Existing (4.1% to 4.9%)				
Code Ref:	CBC 1133B.7.1.3 and ADA/ABA 403.3

As Built Meas:	360	Quantity:	LF
Description:	Cross slope exceeds 2.0% (4.1% to 4.9%)		
As Built Desc:	4.4% cross slope		
Solution:	Demolish existing and construct new route		
Bar. Severity:	2 Recommended	Cost Estimate:	\$45,000.00
Implementation Priority:	4	Facility Function:	
Implementation Phase:		Implementation Date:	
Official Responsible:

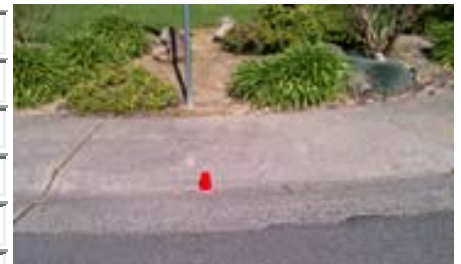
Field Date:	4/1/2011	Report Date:	4/1/2011	Barrier #:	6477
Location:	Cranford Wy and Halesworth Ct - Corner A				
X Coordinate:	-121.24811				
Y Coordinate:	38.69362				
Barrier Area:	Curb Ramps				
Barrier Type:	No Curb Ramp - Depressed Existing Curb				
Code Ref:	CBC 1127B.5.1 and ADA/ABA 402.2

As Built Meas:	1	Quantity:	EACH
Description:	No compliant curb cut at corner (intersection)		
As Built Desc:	10.6% running slope at depressed area		
Solution:	Demolish existing and construct curb cut		
Bar. Severity:	1 Necessary	Cost Estimate:	\$2,500.00
Implementation Priority:	4	Facility Function:	
Implementation Phase:		Implementation Date:	
Official Responsible:

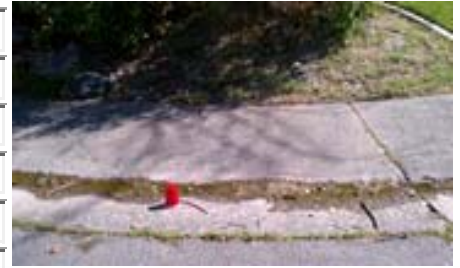
Field Date:	4/1/2011	Report Date:	4/1/2011	Barrier #:	6478
Location:	Cranford Wy and Halesworth Ct - Corner B				
X Coordinate:	-121.24794				
Y Coordinate:	38.69363				
Barrier Area:	Curb Ramps				
Barrier Type:	No Curb Ramp - Depressed Existing Curb				
Code Ref:	CBC 1127B.5.1 and ADA/ABA 402.2

As Built Meas:	1	Quantity:	EACH
Description:	No compliant curb cut at corner (intersection)		
As Built Desc:	8.8% running slope at depressed area		
Solution:	Demolish existing and construct curb cut		
Bar. Severity:	1 Necessary	Cost Estimate:	\$2,500.00
Implementation Priority:	4	Facility Function:	
Implementation Phase:		Implementation Date:	
Official Responsible:			
Notes:	Two - way intersection corners A,B

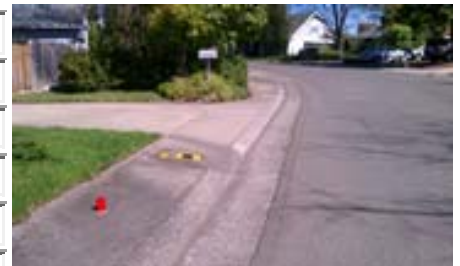
Field Date:	4/1/2011	Report Date:	4/1/2011	Barrier #:	6479
Location:	Halesworth Ct - West				
X Coordinate:	-121.24813				
Y Coordinate:	38.69378				
Barrier Area:	Sidewalks				
Barrier Type:	Cross Slope - Existing (4.1% to 4.9%)				
Code Ref:	CBC 1133B.7.1.3 and ADA/ABA 403.3

As Built Meas:	352	Quantity:	LF
Description:	Cross slope exceeds 2.0% (4.1% to 4.9%)		
As Built Desc:	4.4% cross slope		
Solution:	Demolish existing and construct new route		
Bar. Severity:	2 Recommended	Cost Estimate:	\$44,000.00
Implementation Priority:	4	Facility Function:	
Implementation Phase:		Implementation Date:	
Official Responsible:			
Notes:

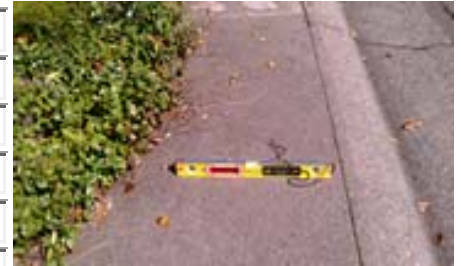
Field Date:	4/1/2011	Report Date:	4/1/2011	Barrier #:	6480
Location:	Halesworth Ct - West				
X Coordinate:	-121.24808				
Y Coordinate:	38.69382				
Barrier Area:	Sidewalks				
Barrier Type:	Clear Width - Existing ($\leq 31"$ or less)				
Code Ref:	CBC 1133B.7.1

As Built Meas:	1	Quantity:	LF
Description:	Pedestrian route is not min. 48" wide ($\leq 31"$ or less)		
As Built Desc:	24" clear width due to foliage		
Solution:	Trim foliage to provide min. 48" clear width		
Bar. Severity:	1 Necessary	Cost Estimate:	\$125.00
Implementation Priority:	4	Facility Function:	
Implementation Phase:		Implementation Date:	
Official Responsible:			
Notes:

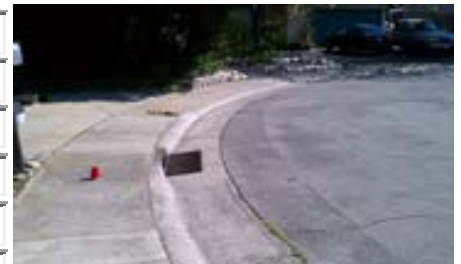
Field Date:	4/1/2011	Report Date:	4/1/2011	Barrier #:	6481
Location:	Halesworth Ct - East				
X Coordinate:	-121.24836				
Y Coordinate:	38.69436				
Barrier Area:	Sidewalks				
Barrier Type:	Cross Slope - Existing (5.0% or more)				
Code Ref:	CBC 1133B.7.1.3 and ADA/ABA 403.3

As Built Meas:	382	Quantity:	LF
Description:	Cross slope exceeds 2.0% (5.0% or more)		
As Built Desc:	5.3% cross slope		
Solution:	Demolish existing and construct new route		
Bar. Severity:	1 Necessary	Cost Estimate:	\$47,750.00
Implementation Priority:	4	Facility Function:	
Implementation Phase:		Implementation Date:	
Official Responsible:			
Notes:

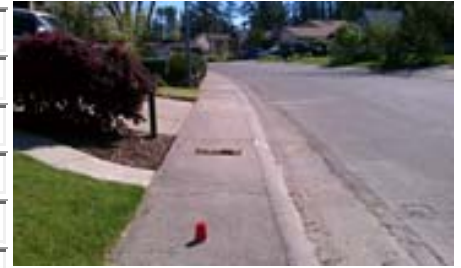
Field Date:	4/1/2011	Report Date:	4/1/2011	Barrier #:	6482
Location:	Cranford Wy - North				
X Coordinate:	-121.24786				
Y Coordinate:	38.69362				
Barrier Area:	Sidewalks				
Barrier Type:	Cross Slope - Existing (3.1% to 4.0%)				
Code Ref:	CBC 1133B.7.1.3 and ADA/ABA 403.3

As Built Meas:	339	Quantity:	LF
Description:	Cross slope exceeds 2.0% (3.1% to 4.0%)		
As Built Desc:	4.0% cross slope		
Solution:	Demolish existing and construct new route		
Bar. Severity:	3 Hindrance	Cost Estimate:	\$42,375.00
Implementation Priority:	4	Facility Function:	
Implementation Phase:		Implementation Date:	
Official Responsible:

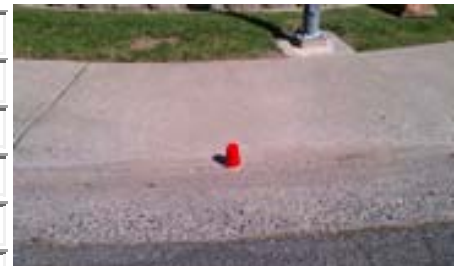
Field Date:	4/1/2011	Report Date:	4/1/2011	Barrier #:	6483
Location:	Cranford Wy and Kingsmill Wy - Corner A				
X Coordinate:	-121.24674				
Y Coordinate:	38.69403				
Barrier Area:	Curb Ramps				
Barrier Type:	No Curb Ramp - Depressed Existing Curb				
Code Ref:	CBC 1127B.5.1 and ADA/ABA 402.2

As Built Meas:	1	Quantity:	EACH
Description:	No compliant curb cut at corner (intersection)		
As Built Desc:	11.8% running slope at depressed area		
Solution:	Demolish existing and construct curb cut		
Bar. Severity:	1 Necessary	Cost Estimate:	\$2,500.00
Implementation Priority:	4	Facility Function:	
Implementation Phase:		Implementation Date:	
Official Responsible:

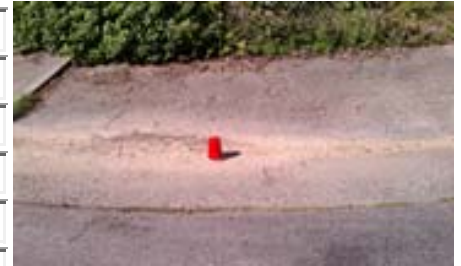
Barrier Type: No Curb Ramp - Depressed Existing Curb

As Built Meas: 1 Quantity: EACH

Description: No compliant curb cut at corner (intersection)

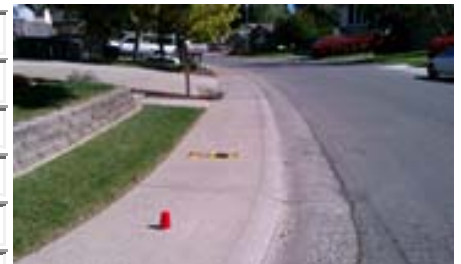
Barrier Type: Cross Slope - Existing (5.0% or more)

As Built Meas: 357 Quantity: LF

Description: Cross slope exceeds 2.0% (5.0% or more)

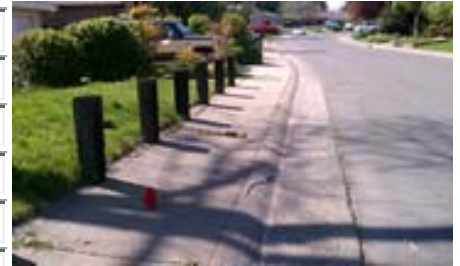
Field Date:	4/1/2011	Report Date:	4/1/2011	Barrier #:	6486A
Location:	Cranford Wy - East				
X Coordinate:	-121.24618				
Y Coordinate:	38.69487				
Barrier Area:	Sidewalks				
Barrier Type:	Cross Slope - Existing (4.1% to 4.9%)				
Code Ref:	CBC 1133B.7.1.3 and ADA/ABA 403.3

As Built Meas:	402	Quantity:	LF
Description:	Cross slope exceeds 2.0% (4.1% to 4.9%)		
As Built Desc:	4.4% cross slope		
Solution:	Demolish existing and construct new route		
Bar. Severity:	2 Recommended	Cost Estimate:	\$50,250.00
Implementation Priority:	4	Facility Function:	
Implementation Phase:		Implementation Date:	
Official Responsible:

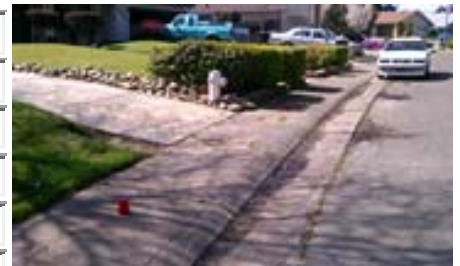
Field Date:	4/1/2011	Report Date:	4/1/2011	Barrier #:	6486B
Location:	Cranford Wy - East				
X Coordinate:	-121.24671				
Y Coordinate:	38.69389				
Barrier Area:	Sidewalks				
Barrier Type:	Surface Condition - Damaged				
Code Ref:	CBC 1133B.7.1 and ADA/ABA 302.1

As Built Meas:	20	Quantity:	LF
Description:	Surface is not firm and stable (cracked, broken or loose soil, etc.)		
As Built Desc:	Cracked concrete		
Solution:	Repair surface to make firm and stable		
Bar. Severity:	1 Necessary	Cost Estimate:	\$2,500.00
Implementation Priority:	4	Facility Function:	
Implementation Phase:		Implementation Date:	
Official Responsible:

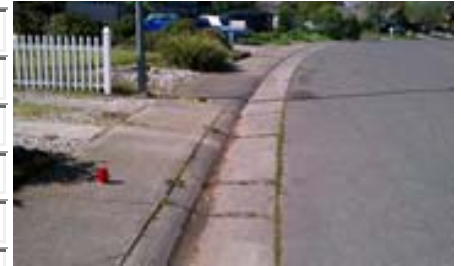
Field Date:	4/1/2011	Report Date:	4/1/2011	Barrier #:	6487
Location:	Cranford Wy - South				
X Coordinate:	-121.247				
Y Coordinate:	38.69367				
Barrier Area:	Sidewalks				
Barrier Type:	Cross Slope - Existing (5.0% or more)				
Code Ref:	CBC 1133B.7.1.3 and ADA/ABA 403.3

As Built Meas:	895	Quantity:	LF
Description:	Cross slope exceeds 2.0% (5.0% or more)		
As Built Desc:	5.1% cross slope		
Solution:	Demolish existing and construct new route		
Bar. Severity:	1 Necessary	Cost Estimate:	\$111,875.00
Implementation Priority:	4	Facility Function:	
Implementation Phase:		Implementation Date:	
Official Responsible:

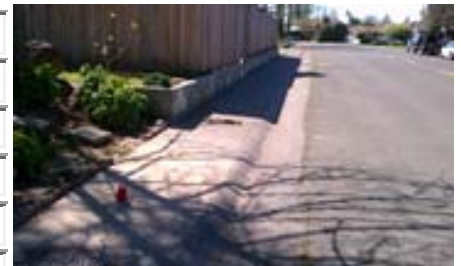
Field Date:	4/1/2011	Report Date:	4/1/2011	Barrier #:	6488
Location:	Old Ranch Rd - East				
X Coordinate:	-121.24964				
Y Coordinate:	38.69342				
Barrier Area:	Sidewalks				
Barrier Type:	Cross Slope - Existing (3.1% to 4.0%)				
Code Ref:	CBC 1133B.7.1.3 and ADA/ABA 403.3

As Built Meas:	109	Quantity:	LF
Description:	Cross slope exceeds 2.0% (3.1% to 4.0%)		
As Built Desc:	3.1% cross slope		
Solution:	Demolish existing and construct new route		
Bar. Severity:	3 Hindrance	Cost Estimate:	\$13,625.00
Implementation Priority:	3	Facility Function:	
Implementation Phase:		Implementation Date:	
Official Responsible:

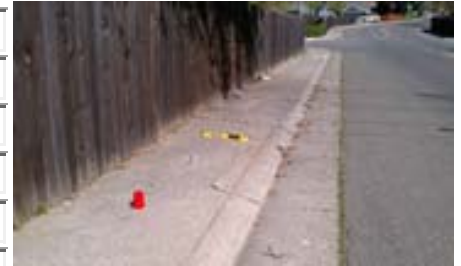
Field Date:	4/1/2011	Report Date:	4/1/2011	Barrier #:	6489A
Location:	Old Ranch Rd - West				
X Coordinate:	-121.24981				
Y Coordinate:	38.69324				
Barrier Area:	Sidewalks				
Barrier Type:	Cross Slope - Existing (4.1% to 4.9%)				
Code Ref:	CBC 1133B.7.1.3 and ADA/ABA 403.3

As Built Meas:	109	Quantity:	LF
Description:	Cross slope exceeds 2.0% (4.1% to 4.9%)		
As Built Desc:	4.2% cross slope		
Solution:	Demolish existing and construct new route		
Bar. Severity:	2 Recommended	Cost Estimate:	\$13,625.00
Implementation Priority:	3	Facility Function:	
Implementation Phase:		Implementation Date:	
Official Responsible:

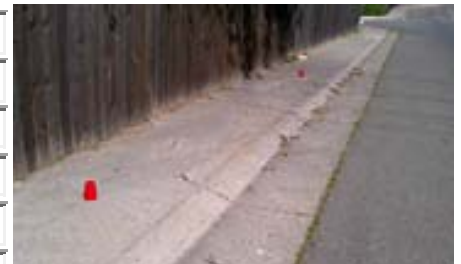
Field Date:	4/1/2011	Report Date:	4/1/2011	Barrier #:	6489B
Location:	Old Ranch Rd - West				
X Coordinate:	-121.24981				
Y Coordinate:	38.69324				
Barrier Area:	Sidewalks				
Barrier Type:	Surface Condition - Damaged				
Code Ref:	CBC 1133B.7.1 and ADA/ABA 302.1

As Built Meas:	24	Quantity:	LF
Description:	Surface is not firm and stable (cracked, broken or loose soil, etc.)		
As Built Desc:	Cracked concrete		
Solution:	Repair surface to make firm and stable		
Bar. Severity:	1 Necessary	Cost Estimate:	\$3,000.00
Implementation Priority:	3	Facility Function:	
Implementation Phase:		Implementation Date:	
Official Responsible:

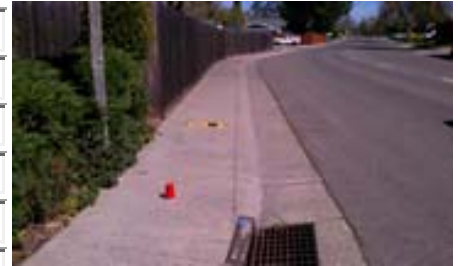
Field Date:	4/1/2011	Report Date:	4/1/2011	Barrier #:	6490
Location:	Old Ranch Rd - West				
X Coordinate:	-121.2498				
Y Coordinate:	38.69367				
Barrier Area:	Sidewalks				
Barrier Type:	Cross Slope - Existing (3.1% to 4.0%)				
Code Ref:	CBC 1133B.7.1.3 and ADA/ABA 403.3

As Built Meas:	194	Quantity:	LF
Description:	Cross slope exceeds 2.0% (3.1% to 4.0%)		
As Built Desc:	3.7% cross slope		
Solution:	Demolish existing and construct new route		
Bar. Severity:	3 Hindrance	Cost Estimate:	\$24,250.00
Implementation Priority:	3	Facility Function:	
Implementation Phase:		Implementation Date:	
Official Responsible:

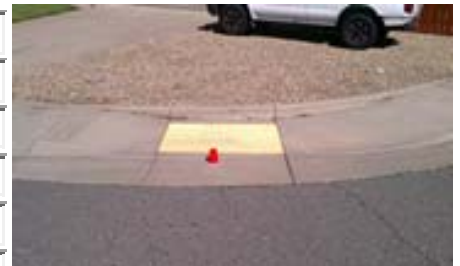
Field Date:	4/1/2011	Report Date:	4/1/2011	Barrier #:	6491A
Location:	Old Ranch Rd and Beckwith Wy - Corner A				
X Coordinate:	-121.24967				
Y Coordinate:	38.69432				
Barrier Area:	Curb Ramps				
Barrier Type:	12" Grooves - Existing (>5.0%)				
Code Ref:	CBC 1127B.5.6

As Built Meas:	1	Quantity:	EACH
Description:	12" grooves at top of curb ramp are not level (>5.0%)		
As Built Desc:	6.3% at 12" grooves		
Solution:	Demolish existing and construct new curb ramp		
Bar. Severity:	1 Necessary	Cost Estimate:	\$2,500.00
Implementation Priority:	3	Facility Function:	
Implementation Phase:		Implementation Date:	
Official Responsible:

Notes:	Two - way intersection corners A,D. Corner D compliant
--------	--

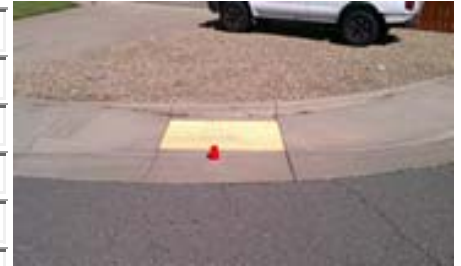
Field Date:	4/1/2011	Report Date:	4/1/2011	Barrier #:	6491B
Location:	Old Ranch Rd and Beckwith Wy - Corner A				
X Coordinate:	-121.24967				
Y Coordinate:	38.69432				
Barrier Area:	Curb Ramps				
Barrier Type:	Running Slope - Existing (9.0% to 9.4%)				
Code Ref:	CBC 1127B.5.3 and ADA/ABA 406.1

As Built Meas:	1	Quantity:	EACH
Description:	Ramp run cross slope exceeds 2.0% (9.0% to 9.4%)		
As Built Desc:	9.3% running slope		
Solution:	Demolish existing and construct new curb ramp		
Bar. Severity:	2 Recommended	Cost Estimate:	\$0.00
Implementation Priority:	3	Facility Function:	
Implementation Phase:		Implementation Date:	
Official Responsible:

Notes: Two - way intersection corners A,D. Corner D compliant

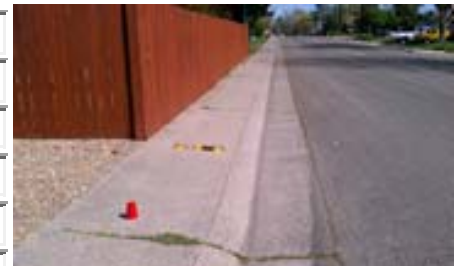
Field Date:	4/1/2011	Report Date:	4/1/2011	Barrier #:	6492A
Location:	Old Ranch Rd - West				
X Coordinate:	-121.24963				
Y Coordinate:	38.69437				
Barrier Area:	Sidewalks				
Barrier Type:	Cross Slope - Existing (4.1% to 4.9%)				
Code Ref:	CBC 1133B.7.1.3 and ADA/ABA 403.3

As Built Meas:	375	Quantity:	LF
Description:	Cross slope exceeds 2.0% (4.1% to 4.9%)		
As Built Desc:	4.3% cross slope		
Solution:	Demolish existing and construct new route		
Bar. Severity:	2 Recommended	Cost Estimate:	\$46,875.00
Implementation Priority:	3	Facility Function:	
Implementation Phase:		Implementation Date:	
Official Responsible:

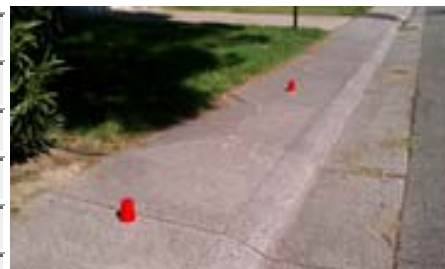
Field Date:	4/1/2011	Report Date:	4/1/2011	Barrier #:	6492B
Location:	Old Ranch Rd - West				
X Coordinate:	-121.24956				
Y Coordinate:	38.69461				
Barrier Area:	Sidewalks				
Barrier Type:	Surface Condition - Damaged				
Code Ref:	CBC 1133B.7.1 and ADA/ABA 302.1

As Built Meas:	12	Quantity:	LF
Description:	Surface is not firm and stable (cracked, broken or loose soil, etc.)		
As Built Desc:	Cracked concrete		
Solution:	Repair surface to make firm and stable		
Bar. Severity:	1 Necessary	Cost Estimate:	\$1,500.00
Implementation Priority:	3	Facility Function:	
Implementation Phase:		Implementation Date:	
Official Responsible:			
Notes:

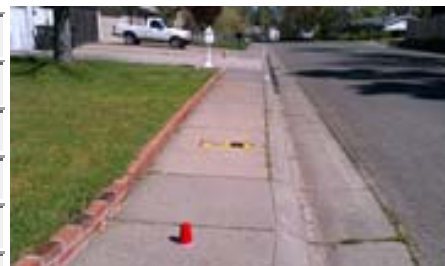
Field Date:	4/1/2011	Report Date:	4/1/2011	Barrier #:	6493A
Location:	Old Ranch Rd - West				
X Coordinate:	-121.24928				
Y Coordinate:	38.69553				
Barrier Area:	Sidewalks				
Barrier Type:	Cross Slope - Existing (5.0% or more)				
Code Ref:	CBC 1133B.7.1.3 and ADA/ABA 403.3

As Built Meas:	1349	Quantity:	LF
Description:	Cross slope exceeds 2.0% (5.0% or more)		
As Built Desc:	5.4% cross slope		
Solution:	Demolish existing and construct new route		
Bar. Severity:	1 Necessary	Cost Estimate:	\$168,625.00
Implementation Priority:	3	Facility Function:	
Implementation Phase:		Implementation Date:	
Official Responsible:			
Notes:

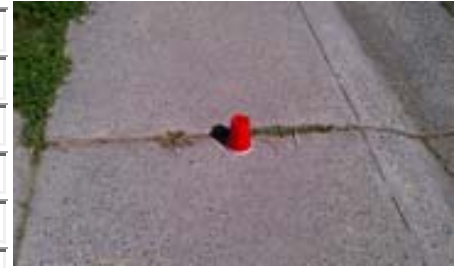
Field Date:	4/1/2011	Report Date:	4/1/2011	Barrier #:	6493B
Location:	Old Ranch Rd - West				
X Coordinate:	-121.24909				
Y Coordinate:	38.69623				
Barrier Area:	Sidewalks				
Barrier Type:	Abrupt Change in Level - > 1/2"				
Code Ref:	CBC 1133B.7.1 and ADA/ABA 303.3

As Built Meas:	4	Quantity:	LF
Description:	Change in level greater than 1/2"		
As Built Desc:	1/2" lip in sidewalk surface		
Solution:	Grind or repair sidewalk to remove trip hazard		
Bar. Severity:	1 Necessary	Cost Estimate:	\$1,000.00
Implementation Priority:	3	Facility Function:	
Implementation Phase:		Implementation Date:	
Official Responsible:			
Notes:

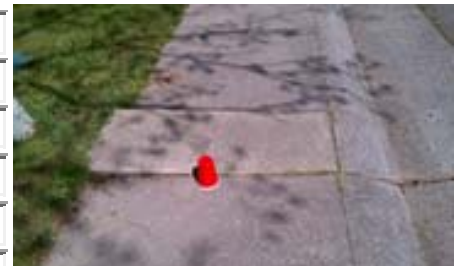
Field Date:	4/1/2011	Report Date:	4/1/2011	Barrier #:	6493C
Location:	Old Ranch Rd - West				
X Coordinate:	-121.2491				
Y Coordinate:	38.69637				
Barrier Area:	Sidewalks				
Barrier Type:	Abrupt Change in Level - > 1/2"				
Code Ref:	CBC 1133B.7.1 and ADA/ABA 303.3

As Built Meas:	4	Quantity:	LF
Description:	Change in level greater than 1/2"		
As Built Desc:	1/2" lip in sidewalk surface		
Solution:	Grind or repair sidewalk to remove trip hazard		
Bar. Severity:	1 Necessary	Cost Estimate:	\$1,000.00
Implementation Priority:	3	Facility Function:	
Implementation Phase:		Implementation Date:	
Official Responsible:			
Notes:

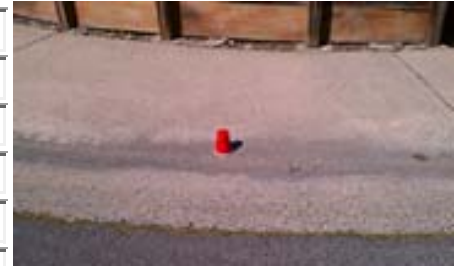
Field Date:	4/1/2011	Report Date:	4/1/2011	Barrier #:	6494
Location:	Old Ranch Rd and Haliburton Ct - Corner A				
X Coordinate:	-121.24978				
Y Coordinate:	38.69732				
Barrier Area:	Curb Ramps				
Barrier Type:	No Curb Ramp - Depressed Existing Curb				
Code Ref:	CBC 1127B.5.1 and ADA/ABA 402.2

As Built Meas:	1	Quantity:	EACH
Description:	No compliant curb cut at corner (intersection)		
As Built Desc:	8.4% running slope at depressed area		
Solution:	Demolish existing and construct curb cut		
Bar. Severity:	1 Necessary	Cost Estimate:	\$2,500.00
Implementation Priority:	3	Facility Function:	
Implementation Phase:		Implementation Date:	
Official Responsible:

Notes:	Two - way intersection corners A,D
--------	------------------------------------

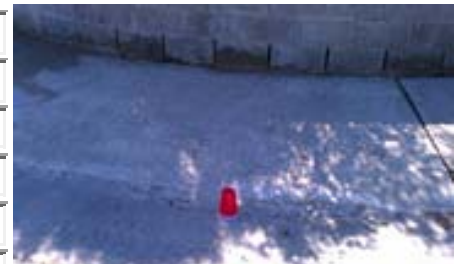
Field Date:	4/1/2011	Report Date:	4/1/2011	Barrier #:	6495
Location:	Old Ranch Rd and Haliburton Ct - Corner D				
X Coordinate:	-121.24969				
Y Coordinate:	38.69725				
Barrier Area:	Curb Ramps				
Barrier Type:	No Curb Ramp - Depressed Existing Curb				
Code Ref:	CBC 1127B.5.1 and ADA/ABA 402.2

As Built Meas:	1	Quantity:	EACH
Description:	No compliant curb cut at corner (intersection)		
As Built Desc:	8.9% running slope at depressed area		
Solution:	Demolish existing and construct curb cut		
Bar. Severity:	1 Necessary	Cost Estimate:	\$2,500.00
Implementation Priority:	3	Facility Function:	
Implementation Phase:		Implementation Date:	
Official Responsible:

Notes:	Two - way intersection corners A,D
--------	------------------------------------

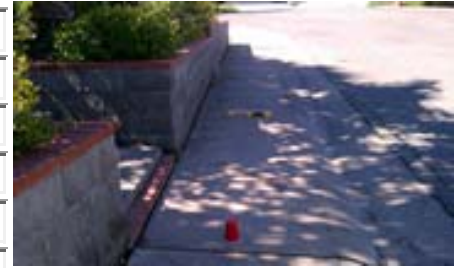
Barrier Type: Cross Slope - Existing (5.0% or more)

Code Ref: CBC 1133B.7.1.3 and ADA/ABA 403.3

As Built Meas: 182 Quantity: LF

Description: Cross slope exceeds 2.0% (5.0% or more)

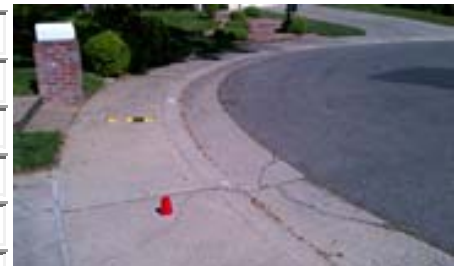
Barrier Type: Cross Slope - Existing (4.1% to 4.9%)

Code Ref: CBC 1133B.7.1.3 and ADA/ABA 403.3

As Built Meas: 203 Quantity: LF

Description: Cross slope exceeds 2.0% (4.1% to 4.9%)
