DRAFT ADA TRANSITION PLAN UPDATE
NEIGHBORHOOD AREA 9 SONA
SEPTEMBER 20, 2011

CITY OF CITRUS HEIGHTS

The Sunrise Oaks Neighborhood Association (SONA)

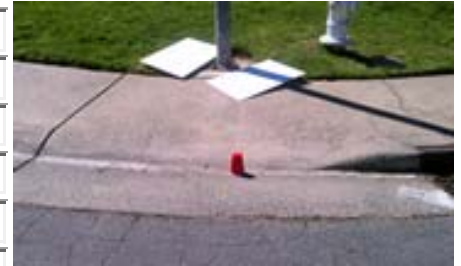
Field Date:	4/1/2011	Report Date:	4/1/2011	Barrier #:	6500
Location:	Old Ranch Rd and Streng - Corner D				
X Coordinate:	-121.25031				
Y Coordinate:	38.69773				
Barrier Area:	Curb Ramps				
Barrier Type:	No Curb Ramp - Depressed Existing Curb				
Code Ref:	CBC 1127B.5.1 and ADA/ABA 402.2

As Built Meas:	1	Quantity:	EACH
Description:	No compliant curb cut at corner (intersection)		
As Built Desc:	12.8% running slope at depressed area		
Solution:	Demolish existing and construct curb cut		
Bar. Severity:	1 Necessary	Cost Estimate:	\$2,500.00
Implementation Priority:	3	Facility Function:	
Implementation Phase:		Implementation Date:	
Official Responsible:			
Notes:	Two - way intersection corners A,D

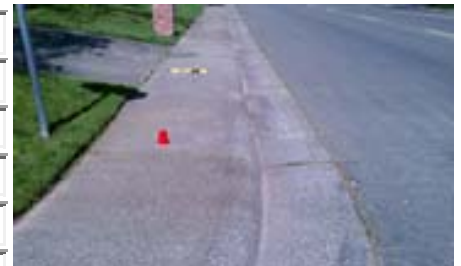
Field Date:	4/1/2011	Report Date:	4/1/2011	Barrier #:	6501
Location:	Old Ranch Rd - West				
X Coordinate:	-121.25056				
Y Coordinate:	38.69795				
Barrier Area:	Sidewalks				
Barrier Type:	Cross Slope - Existing (5.0% or more)				
Code Ref:	CBC 1133B.7.1.3 and ADA/ABA 403.3

As Built Meas:	693	Quantity:	LF
Description:	Cross slope exceeds 2.0% (5.0% or more)		
As Built Desc:	5.3% cross slope		
Solution:	Demolish existing and construct new route		
Bar. Severity:	1 Necessary	Cost Estimate:	\$86,625.00
Implementation Priority:	3	Facility Function:	
Implementation Phase:		Implementation Date:	
Official Responsible:			
Notes:

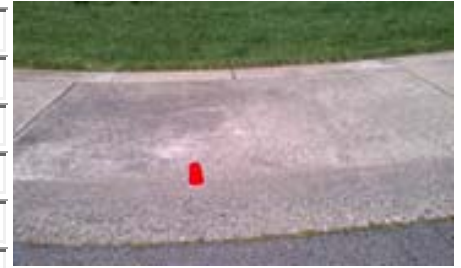
Field Date:	4/1/2011	Report Date:	4/1/2011	Barrier #:	6502
Location:	Old Ranch Rd and Blayden Ct - Corner A				
X Coordinate:	-121.25166				
Y Coordinate:	38.69966				
Barrier Area:	Curb Ramps				
Barrier Type:	No Curb Ramp - Depressed Existing Curb				
Code Ref:	CBC 1127B.5.1 and ADA/ABA 402.2

As Built Meas:	1	Quantity:	EACH
Description:	No compliant curb cut at corner (intersection)		
As Built Desc:	12.6% running slope at depressed area		
Solution:	Demolish existing and construct curb cut		
Bar. Severity:	1 Necessary	Cost Estimate:	\$2,500.00
Implementation Priority:	3	Facility Function:	
Implementation Phase:		Implementation Date:	
Official Responsible:

Notes: Two - way intersection corners A,D

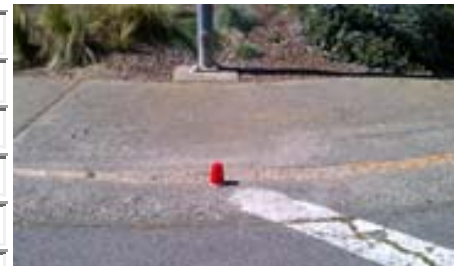
Field Date:	4/1/2011	Report Date:	4/1/2011	Barrier #:	6503
Location:	Old Ranch Rd and Blayden Ct - Corner D				
X Coordinate:	-121.25161				
Y Coordinate:	38.69953				
Barrier Area:	Curb Ramps				
Barrier Type:	No Curb Ramp - Depressed Existing Curb				
Code Ref:	CBC 1127B.5.1 and ADA/ABA 402.2

As Built Meas:	1	Quantity:	EACH
Description:	No compliant curb cut at corner (intersection)		
As Built Desc:	11.8% running slope at depressed area		
Solution:	Demolish existing and construct curb cut		
Bar. Severity:	1 Necessary	Cost Estimate:	\$2,500.00
Implementation Priority:	3	Facility Function:	
Implementation Phase:		Implementation Date:	
Official Responsible:

Notes: Two - way intersection corners A,D

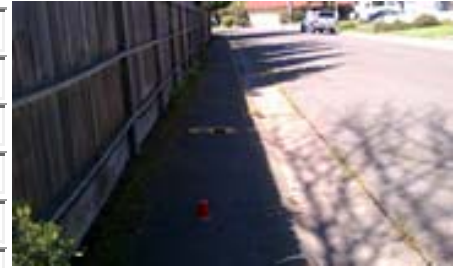
Field Date:	4/1/2011	Report Date:	4/1/2011	Barrier #:	6504
Location:	Blayden Ct - South				
X Coordinate:	-121.25182				
Y Coordinate:	38.69955				
Barrier Area:	Sidewalks				
Barrier Type:	Cross Slope - Existing (5.0% or more)				
Code Ref:	CBC 1133B.7.1.3 and ADA/ABA 403.3

As Built Meas:	196	Quantity:	LF
Description:	Cross slope exceeds 2.0% (5.0% or more)		
As Built Desc:	5.3% cross slope		
Solution:	Demolish existing and construct new route		
Bar. Severity:	1 Necessary	Cost Estimate:	\$24,500.00
Implementation Priority:	4	Facility Function:	
Implementation Phase:		Implementation Date:	
Official Responsible:

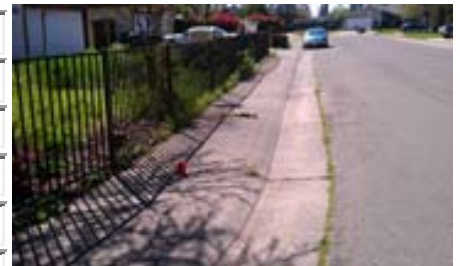
Field Date:	4/1/2011	Report Date:	4/1/2011	Barrier #:	6505A
Location:	Blayden Ct - East				
X Coordinate:	-121.25246				
Y Coordinate:	38.69948				
Barrier Area:	Sidewalks				
Barrier Type:	Cross Slope - Existing (3.1% to 4.0%)				
Code Ref:	CBC 1133B.7.1.3 and ADA/ABA 403.3

As Built Meas:	325	Quantity:	LF
Description:	Cross slope exceeds 2.0% (3.1% to 4.0%)		
As Built Desc:	3.7% cross slope		
Solution:	Demolish existing and construct new route		
Bar. Severity:	3 Hindrance	Cost Estimate:	\$40,625.00
Implementation Priority:	4	Facility Function:	
Implementation Phase:		Implementation Date:	
Official Responsible:

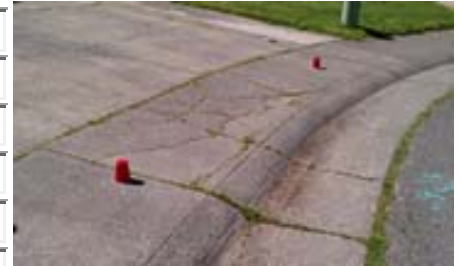
Field Date:	4/1/2011	Report Date:	4/1/2011	Barrier #:	6505B
Location:	Blayden Ct - East				
X Coordinate:	-121.25241				
Y Coordinate:	38.6988				
Barrier Area:	Sidewalks				
Barrier Type:	Surface Condition - Damaged				
Code Ref:	CBC 1133B.7.1 and ADA/ABA 302.1

As Built Meas:	4	Quantity:	LF
Description:	Surface is not firm and stable (cracked, broken or loose soil, etc.)		
As Built Desc:	Cracked concrete		
Solution:	Repair surface to make firm and stable		
Bar. Severity:	1 Necessary	Cost Estimate:	\$500.00
Implementation Priority:	4	Facility Function:	
Implementation Phase:		Implementation Date:	
Official Responsible:			
Notes:

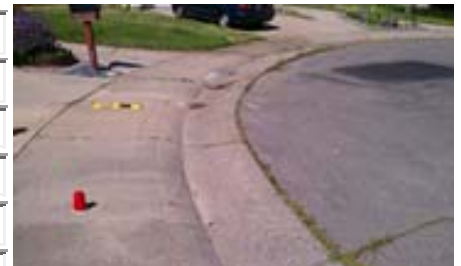
Field Date:	4/1/2011	Report Date:	4/1/2011	Barrier #:	6506
Location:	Blayden Ct - West				
X Coordinate:	-121.25253				
Y Coordinate:	38.6988				
Barrier Area:	Sidewalks				
Barrier Type:	Cross Slope - Existing (4.1% to 4.9%)				
Code Ref:	CBC 1133B.7.1.3 and ADA/ABA 403.3

As Built Meas:	325	Quantity:	LF
Description:	Cross slope exceeds 2.0% (4.1% to 4.9%)		
As Built Desc:	4.4% cross slope		
Solution:	Demolish existing and construct new route		
Bar. Severity:	2 Recommended	Cost Estimate:	\$40,625.00
Implementation Priority:	4	Facility Function:	
Implementation Phase:		Implementation Date:	
Official Responsible:			
Notes:

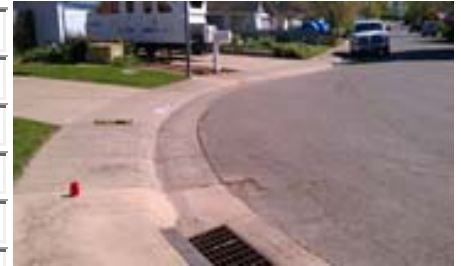
Field Date:	4/1/2011	Report Date:	4/1/2011	Barrier #:	6507
Location:	Blayden Ct - North				
X Coordinate:	-121.25256				
Y Coordinate:	38.69965				
Barrier Area:	Sidewalks				
Barrier Type:	Cross Slope - Existing (5.0% or more)				
Code Ref:	CBC 1133B.7.1.3 and ADA/ABA 403.3

As Built Meas:	206	Quantity:	LF
Description:	Cross slope exceeds 2.0% (5.0% or more)		
As Built Desc:	5.2% cross slope		
Solution:	Demolish existing and construct new route		
Bar. Severity:	1 Necessary	Cost Estimate:	\$25,750.00
Implementation Priority:	4	Facility Function:	
Implementation Phase:		Implementation Date:	
Official Responsible:

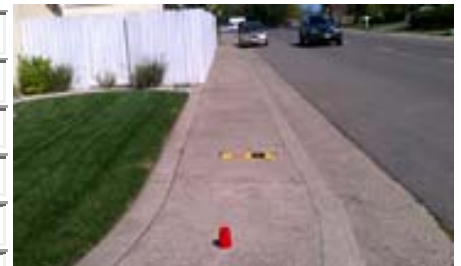
Field Date:	4/1/2011	Report Date:	4/1/2011	Barrier #:	6508
Location:	Old Ranch Rd - West				
X Coordinate:	-121.25162				
Y Coordinate:	38.69971				
Barrier Area:	Sidewalks				
Barrier Type:	Cross Slope - Existing (5.0% or more)				
Code Ref:	CBC 1133B.7.1.3 and ADA/ABA 403.3

As Built Meas:	235	Quantity:	LF
Description:	Cross slope exceeds 2.0% (5.0% or more)		
As Built Desc:	5.2% cross slope		
Solution:	Demolish existing and construct new route		
Bar. Severity:	1 Necessary	Cost Estimate:	\$29,375.00
Implementation Priority:	3	Facility Function:	
Implementation Phase:		Implementation Date:	
Official Responsible:

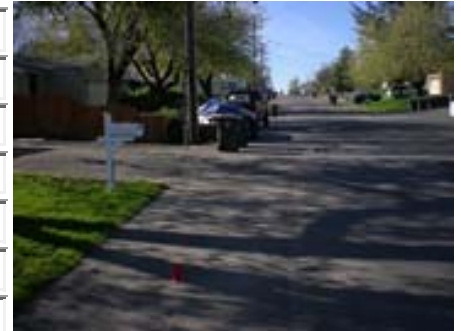
Field Date:	4/4/2011	Report Date:	4/4/2011	Barrier #:	6509
Location:	Melva St - East				
X Coordinate:	-121.2541				
Y Coordinate:	38.70038				
Barrier Area:	Sidewalks				
Barrier Type:	No sidewalk				
Code Ref:	CBC 1127B.1 and ADA/ABA 206.2.1

As Built Meas:	1125	Quantity:	LF
Description:	No pedestrian route provided		
As Built Desc:	No sidewalk provided		
Solution:	Construct new firm and stable pedestrian route		
Bar. Severity:	1 Necessary	Cost Estimate:	\$112,500.00
Implementation Priority:	4	Facility Function:	
Implementation Phase:		Implementation Date:	
Official Responsible:

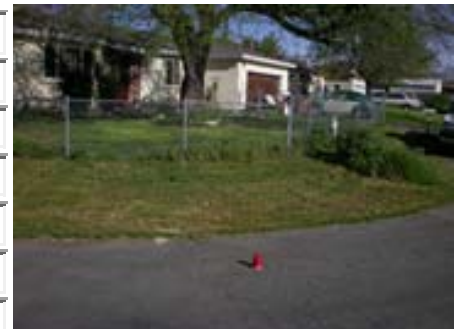
Field Date:	4/4/2011	Report Date:	4/4/2011	Barrier #:	6510
Location:	Melva St and Streng Ave - Corner A				
X Coordinate:	-121.25437				
Y Coordinate:	38.69717				
Barrier Area:	Blended Transitions				
Barrier Type:	Detectable Warnings - Truncated Domes				
Code Ref:	CBC 1127B.5.3

As Built Meas:	1	Quantity:	EACH
Description:	No truncated domes provided at transition into roadway		
As Built Desc:	No detectable warning		
Solution:	Provide compliant truncated domes		
Bar. Severity:	2 Recommended	Cost Estimate:	\$1,400.00
Implementation Priority:	4	Facility Function:	
Implementation Phase:		Implementation Date:	
Official Responsible:

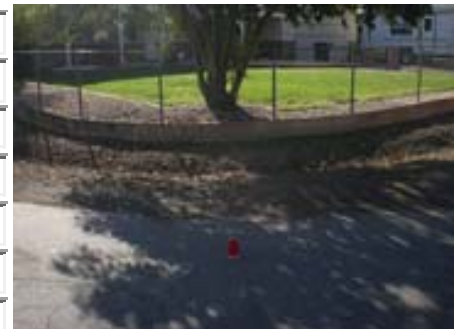
Field Date:	4/4/2011	Report Date:	4/4/2011	Barrier #:	6512
Location:	Melva St and Streng Ave - Corner C				
X Coordinate:	-121.25416				
Y Coordinate:	38.69702				
Barrier Area:	Blended Transitions				
Barrier Type:	Detectable Warnings - Truncated Domes				
Code Ref:	CBC 1127B.5.3

As Built Meas:	1	Quantity:	EACH
Description:	No truncated domes provided at transition into roadway		
As Built Desc:	No detectable warning		
Solution:	Provide compliant truncated domes		
Bar. Severity:	2 Recommended	Cost Estimate:	\$1,400.00
Implementation Priority:	4	Facility Function:	
Implementation Phase:		Implementation Date:	
Official Responsible:			
Notes:	Four - way intersection corners A, B, C, D

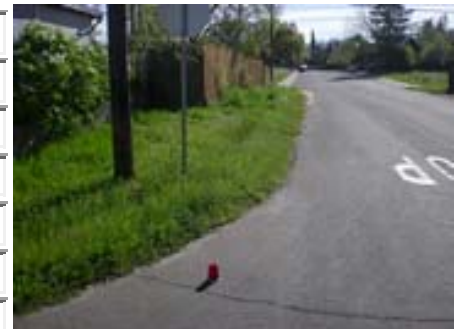
Field Date:	4/4/2011	Report Date:	4/4/2011	Barrier #:	6514
Location:	Streng Ave - North				
X Coordinate:	-121.25413				
Y Coordinate:	38.69711				
Barrier Area:	Sidewalks				
Barrier Type:	No sidewalk				
Code Ref:	CBC 1127B.1 and ADA/ABA 206.2.1

As Built Meas:	160	Quantity:	LF
Description:	No pedestrian route provided		
As Built Desc:	No sidewalk provided		
Solution:	Construct new firm and stable pedestrian route		
Bar. Severity:	1 Necessary	Cost Estimate:	\$16,000.00
Implementation Priority:	4	Facility Function:	
Implementation Phase:		Implementation Date:	
Official Responsible:			
Notes:

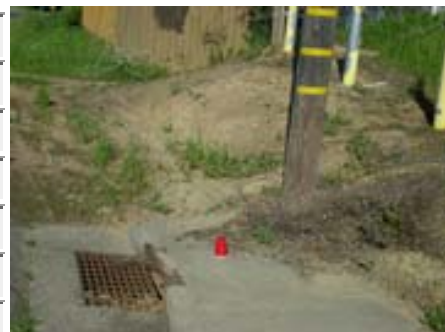
Field Date:	4/4/2011	Report Date:	4/4/2011	Barrier #:	6515
Location:	Streng Ave - North				
X Coordinate:	-121.25364				
Y Coordinate:	38.69715				
Barrier Area:	Sidewalks				
Barrier Type:	No Sidewalk - No Barricade				
Code Ref:	MUTCD Section 6D.01

As Built Meas:	1	Quantity:	JOB
Description:	No barricade provided where sidewalk ends in hazardous location		
As Built Desc:	No barricade or other warning provided for the visually impaired at end of sidewalk		
Solution:	Provide barricade with cane detectable warning at end of sidewalk		
Bar. Severity:	1 Necessary	Cost Estimate:	\$1,350.00
Implementation Priority:	4	Facility Function:	
Implementation Phase:		Implementation Date:	
Official Responsible:			
Notes:

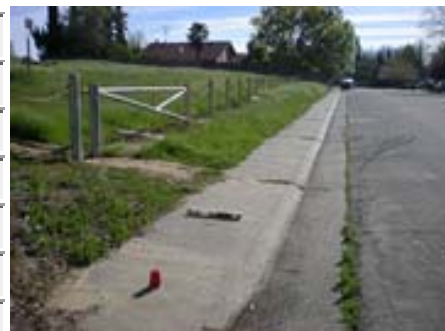
Field Date:	4/4/2011	Report Date:	4/4/2011	Barrier #:	6516
Location:	Streng Ave - North				
X Coordinate:	-121.25356				
Y Coordinate:	38.69716				
Barrier Area:	Sidewalks				
Barrier Type:	Cross Slope - Existing (4.1% to 4.9%)				
Code Ref:	CBC 1133B.7.1.3 and ADA/ABA 403.3

As Built Meas:	625	Quantity:	LF
Description:	Cross slope exceeds 2.0% (4.1% to 4.9%)		
As Built Desc:	4.6% cross slope		
Solution:	Demolish existing and construct new route		
Bar. Severity:	2 Recommended	Cost Estimate:	\$78,125.00
Implementation Priority:	4	Facility Function:	
Implementation Phase:		Implementation Date:	
Official Responsible:			
Notes:

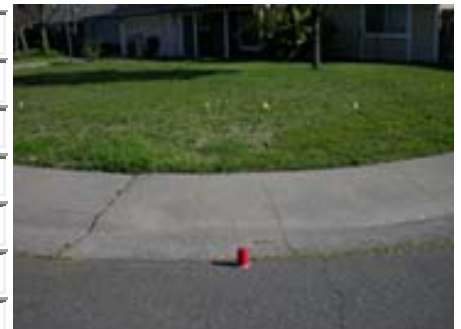
Field Date:	4/4/2011	Report Date:	4/4/2011	Barrier #:	6518
Location:	Streng Ave and Streng Ave CT - Corner B				
X Coordinate:	-121.25114				
Y Coordinate:	38.69741				
Barrier Area:	Curb Ramps				
Barrier Type:	No Curb Ramp - Depressed Existing Curb				
Code Ref:	CBC 1127B.5.1 and ADA/ABA 402.2

As Built Meas:	1	Quantity:	EACH
Description:	No compliant curb cut at corner (intersection)		
As Built Desc:	12.2% running slope at depressed area		
Solution:	Demolish existing and construct curb cut		
Bar. Severity:	1 Necessary	Cost Estimate:	\$2,500.00
Implementation Priority:	4	Facility Function:	
Implementation Phase:		Implementation Date:	
Official Responsible:

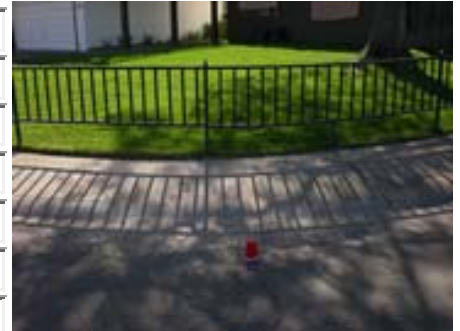
Barrier Type: No Curb Ramp - Depressed Existing Curb

Code Ref: CBC 1127B.5.1 and ADA/ABA 402.2

As Built Meas: 1 Quantity: EACH

Description: No compliant curb cut at corner (intersection)

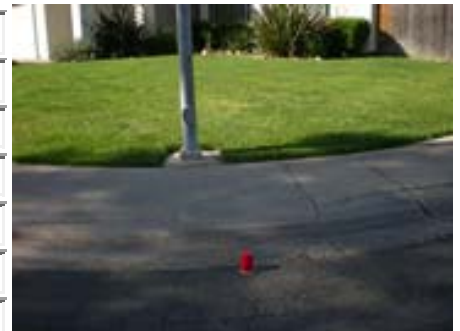
Barrier Type: No Curb Ramp - Depressed Existing Curb

Code Ref: CBC 1127B.5.1 and ADA/ABA 402.2

As Built Meas: 1 Quantity: EACH

Description: No compliant curb cut at corner (intersection)

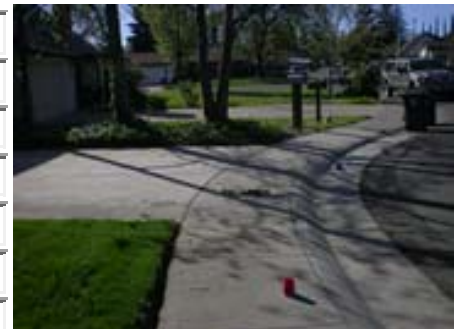
Field Date:	4/4/2011	Report Date:	4/4/2011	Barrier #:	6522
Location:	Streng Ave CT - East				
X Coordinate:	-121.25143				
Y Coordinate:	38.69766				
Barrier Area:	Sidewalks				
Barrier Type:	Cross Slope - Existing (5.0% or more)				
Code Ref:	CBC 1133B.7.1.3 and ADA/ABA 403.3

As Built Meas:	115	Quantity:	LF
Description:	Cross slope exceeds 2.0% (5.0% or more)		
As Built Desc:	5.1% cross slope		
Solution:	Demolish existing and construct new route		
Bar. Severity:	1 Necessary	Cost Estimate:	\$14,375.00
Implementation Priority:	4	Facility Function:	
Implementation Phase:		Implementation Date:	
Official Responsible:

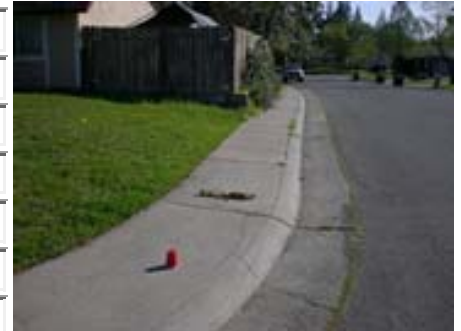
Field Date:	4/4/2011	Report Date:	4/4/2011	Barrier #:	6523
Location:	Streng Ave - North				
X Coordinate:	-121.2511				
Y Coordinate:	38.69743				
Barrier Area:	Sidewalks				
Barrier Type:	Cross Slope - Existing (5.0% or more)				
Code Ref:	CBC 1133B.7.1.3 and ADA/ABA 403.3

As Built Meas:	245	Quantity:	LF
Description:	Cross slope exceeds 2.0% (5.0% or more)		
As Built Desc:	5.0% cross slope		
Solution:	Demolish existing and construct new route		
Bar. Severity:	1 Necessary	Cost Estimate:	\$30,625.00
Implementation Priority:	4	Facility Function:	
Implementation Phase:		Implementation Date:	
Official Responsible:

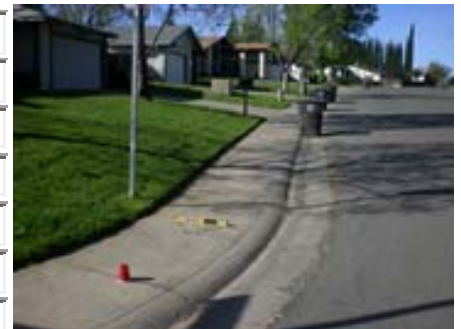
Field Date:	4/4/2011	Report Date:	4/4/2011	Barrier #:	6524
Location:	Streng Ave - South				
X Coordinate:	-121.25043				
Y Coordinate:	38.69767				
Barrier Area:	Sidewalks				
Barrier Type:	Cross Slope - Existing (3.1% to 4.0%)				
Code Ref:	CBC 1133B.7.1.3 and ADA/ABA 403.3

As Built Meas:	270	Quantity:	LF
Description:	Cross slope exceeds 2.0% (3.1% to 4.0%)		
As Built Desc:	3.7% cross slope		
Solution:	Demolish existing and construct new route		
Bar. Severity:	3 Hindrance	Cost Estimate:	\$33,750.00
Implementation Priority:	4	Facility Function:	
Implementation Phase:		Implementation Date:	
Official Responsible:

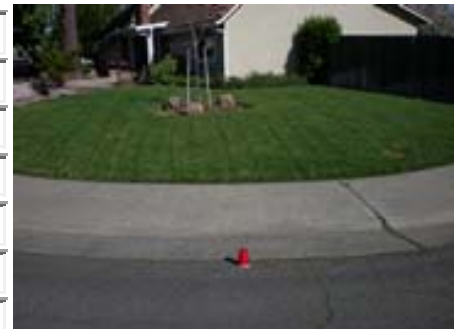
Field Date:	4/4/2011	Report Date:	4/4/2011	Barrier #:	6526
Location:	Kingsmill Ln and Blandford Ct - Corner A				
X Coordinate:	-121.25022				
Y Coordinate:	38.69568				
Barrier Area:	Curb Ramps				
Barrier Type:	No Curb Ramp - Depressed Existing Curb				
Code Ref:	CBC 1127B.5.1 and ADA/ABA 402.2

As Built Meas:	1	Quantity:	EACH
Description:	No compliant curb cut at corner (intersection)		
As Built Desc:	12.7% running slope at depressed area		
Solution:	Demolish existing and construct curb cut		
Bar. Severity:	1 Necessary	Cost Estimate:	\$2,500.00
Implementation Priority:	4	Facility Function:	
Implementation Phase:		Implementation Date:	
Official Responsible:

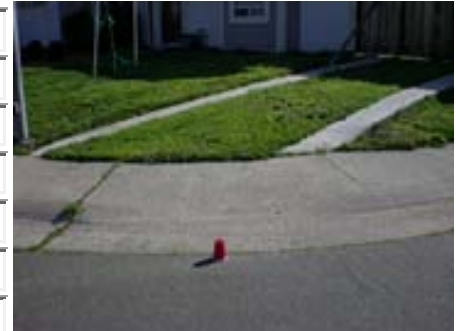
Field Date:	4/4/2011	Report Date:	4/4/2011	Barrier #:	6527
Location:	Kingsmill Ln and Blandford Ct - Corner B				
X Coordinate:	-121.25005				
Y Coordinate:	38.6956				
Barrier Area:	Curb Ramps				
Barrier Type:	No Curb Ramp - Depressed Existing Curb				
Code Ref:	CBC 1127B.5.1 and ADA/ABA 402.2

As Built Meas:	1	Quantity:	EACH
Description:	No compliant curb cut at corner (intersection)		
As Built Desc:	11.8% running slope at depressed area		
Solution:	Demolish existing and construct curb cut		
Bar. Severity:	1 Necessary	Cost Estimate:	\$2,500.00
Implementation Priority:	4	Facility Function:	
Implementation Phase:		Implementation Date:	
Official Responsible:			
Notes:	Four - way intersection A,B,C,D. Corners C,D compliant

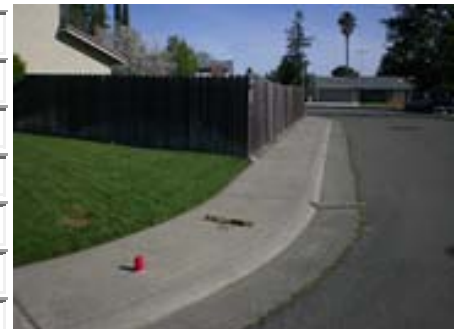
Field Date:	4/4/2011	Report Date:	4/4/2011	Barrier #:	6528A
Location:	Blandford Ct - West				
X Coordinate:	-121.25019				
Y Coordinate:	38.6958				
Barrier Area:	Sidewalks				
Barrier Type:	Cross Slope - Existing (3.1% to 4.0%)				
Code Ref:	CBC 1133B.7.1.3 and ADA/ABA 403.3

As Built Meas:	240	Quantity:	LF
Description:	Cross slope exceeds 2.0% (3.1% to 4.0%)		
As Built Desc:	3.7% cross slope		
Solution:	Demolish existing and construct new route		
Bar. Severity:	3 Hindrance	Cost Estimate:	\$30,000.00
Implementation Priority:	4	Facility Function:	
Implementation Phase:		Implementation Date:	
Official Responsible:			
Notes:

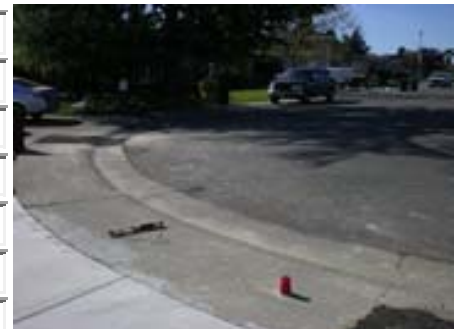
Field Date:	4/4/2011	Report Date:	4/4/2011	Barrier #:	6529A
Location:	Blandford Ct - East				
X Coordinate:	-121.25004				
Y Coordinate:	38.6962				
Barrier Area:	Sidewalks				
Barrier Type:	Cross Slope - Existing (3.1% to 4.0%)				
Code Ref:	CBC 1133B.7.1.3 and ADA/ABA 403.3

As Built Meas:	220	Quantity:	LF
Description:	Cross slope exceeds 2.0% (3.1% to 4.0%)		
As Built Desc:	4.0% cross slope		
Solution:	Demolish existing and construct new route		
Bar. Severity:	3 Hindrance	Cost Estimate:	\$27,500.00
Implementation Priority:	4	Facility Function:	
Implementation Phase:		Implementation Date:	
Official Responsible:			
Notes:

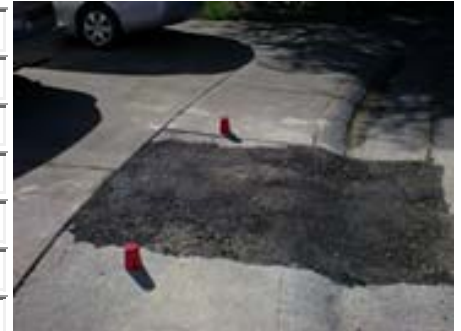
Barrier Type: Surface Condition - Damaged

Code Ref: CBC 1133B.7.1 and ADA/ABA 302.1

As Built Meas: 5 Quantity: LF

Description: Surface is not firm and stable (cracked, broken or loose soil, etc.)

As Built Desc: Cracked concrete

Solution: Repair surface to make firm and stable

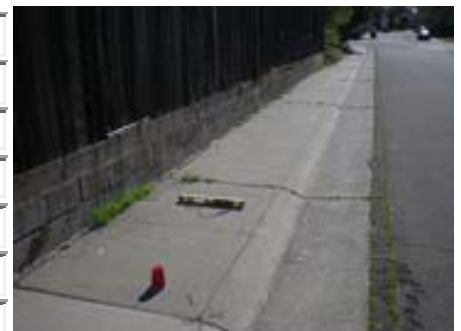
Barrier Type: Cross Slope - Existing (4.1% to 4.9%)

Code Ref: CBC 1133B.7.1.3 and ADA/ABA 403.3

As Built Meas: 170 Quantity: LF

Description: Cross slope exceeds 2.0% (4.1% to 4.9%)

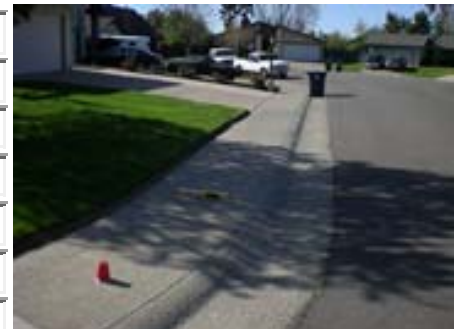
Field Date:	4/4/2011	Report Date:	4/4/2011	Barrier #:	6532
Location:	Gateshead Ct - East				
X Coordinate:	-121.25012				
Y Coordinate:	38.69536				
Barrier Area:	Sidewalks				
Barrier Type:	Cross Slope - Existing (4.1% to 4.9%)				
Code Ref:	CBC 1133B.7.1.3 and ADA/ABA 403.3

As Built Meas:	220	Quantity:	LF
Description:	Cross slope exceeds 2.0% (4.1% to 4.9%)		
As Built Desc:	4.2% cross slope		
Solution:	Demolish existing and construct new route		
Bar. Severity:	2 Recommended	Cost Estimate:	\$27,500.00
Status:			
Implementation Priority:	4	Facility Function:	
Implementation Phase:		Implementation Date:	
Official Responsible:

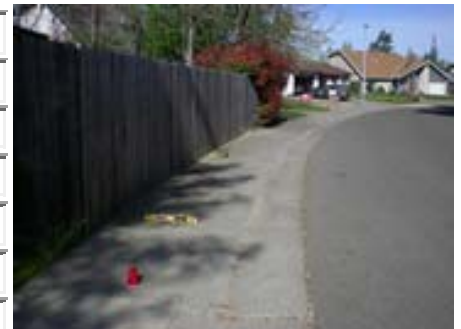
Field Date:	4/4/2011	Report Date:	4/4/2011	Barrier #:	6534
Location:	Kingsmill Ln - South				
X Coordinate:	-121.25042				
Y Coordinate:	38.69554				
Barrier Area:	Sidewalks				
Barrier Type:	Cross Slope - Existing (3.1% to 4.0%)				
Code Ref:	CBC 1133B.7.1.3 and ADA/ABA 403.3

As Built Meas:	159	Quantity:	LF
Description:	Cross slope exceeds 2.0% (3.1% to 4.0%)		
As Built Desc:	3.8% cross slope		
Solution:	Demolish existing and construct new route		
Bar. Severity:	3 Hindrance	Cost Estimate:	\$19,875.00
Implementation Priority:	4	Facility Function:	
Implementation Phase:		Implementation Date:	
Official Responsible:			
Notes:

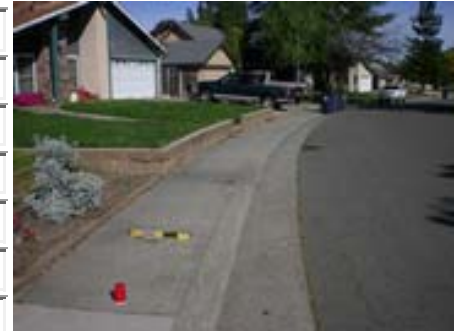
Field Date:	4/4/2011	Report Date:	4/4/2011	Barrier #:	6535
Location:	Kingsmill Ln - West				
X Coordinate:	-121.25088				
Y Coordinate:	38.69588				
Barrier Area:	Sidewalks				
Barrier Type:	Cross Slope - Existing (3.1% to 4.0%)				
Code Ref:	CBC 1133B.7.1.3 and ADA/ABA 403.3

As Built Meas:	491	Quantity:	LF
Description:	Cross slope exceeds 2.0% (3.1% to 4.0%)		
As Built Desc:	4.0% cross slope		
Solution:	Demolish existing and construct new route		
Bar. Severity:	3 Hindrance	Cost Estimate:	\$61,375.00
Implementation Priority:	4	Facility Function:	
Implementation Phase:		Implementation Date:	
Official Responsible:

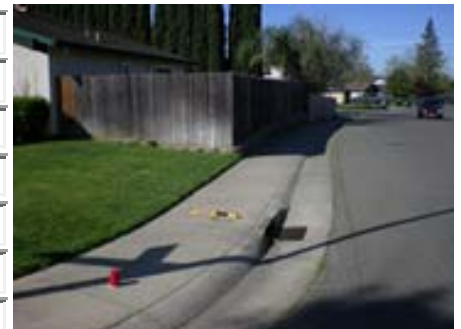
Field Date:	4/4/2011	Report Date:	4/4/2011	Barrier #:	6536
Location:	Streng Ave - South				
X Coordinate:	-121.25135				
Y Coordinate:	38.69717				
Barrier Area:	Sidewalks				
Barrier Type:	Cross Slope - Existing (4.1% to 4.9%)				
Code Ref:	CBC 1133B.7.1.3 and ADA/ABA 403.3

As Built Meas:	180	Quantity:	LF
Description:	Cross slope exceeds 2.0% (4.1% to 4.9%)		
As Built Desc:	4.2% cross slope		
Solution:	Demolish existing and construct new route		
Bar. Severity:	2 Recommended	Cost Estimate:	\$22,500.00
Implementation Priority:	4	Facility Function:	
Implementation Phase:		Implementation Date:	
Official Responsible:

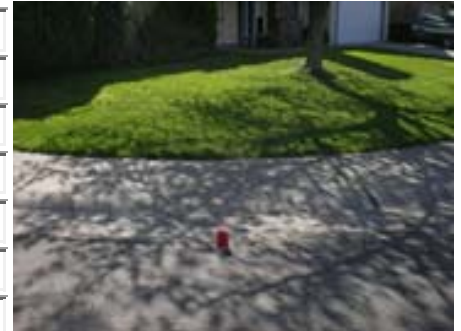
Field Date:	4/4/2011	Report Date:	4/4/2011	Barrier #:	6537
Location:	Streng Ave and Escallonia Dr - Corner C				
X Coordinate:	-121.25191				
Y Coordinate:	38.69701				
Barrier Area:	Curb Ramps				
Barrier Type:	No Curb Ramp - Depressed Existing Curb				
Code Ref:	CBC 1127B.5.1 and ADA/ABA 402.2

As Built Meas:	1	Quantity:	EACH
Description:	No compliant curb cut at corner (intersection)		
As Built Desc:	9.8% running slope at depressed area		
Solution:	Demolish existing and construct curb cut		
Bar. Severity:	1 Necessary	Cost Estimate:	\$2,500.00
Implementation Priority:	4	Facility Function:	
Implementation Phase:		Implementation Date:	
Official Responsible:			
Notes:	Two - way intersection corners C,D

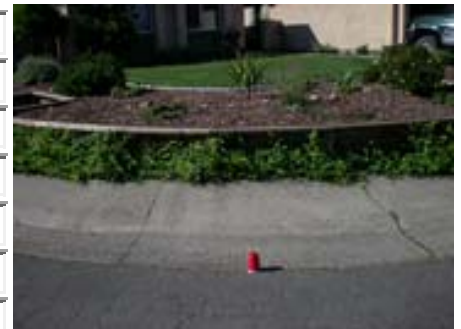
Field Date:	4/4/2011	Report Date:	4/4/2011	Barrier #:	6538
Location:	Streng Ave and Escallonia Dr - Corner D				
X Coordinate:	-121.2522				
Y Coordinate:	38.69699				
Barrier Area:	Curb Ramps				
Barrier Type:	No Curb Ramp - Depressed Existing Curb				
Code Ref:	CBC 1127B.5.1 and ADA/ABA 402.2

As Built Meas:	1	Quantity:	EACH
Description:	No compliant curb cut at corner (intersection)		
As Built Desc:	11.1% running slope at depressed area		
Solution:	Demolish existing and construct curb cut		
Bar. Severity:	1 Necessary	Cost Estimate:	\$2,500.00
Implementation Priority:	4	Facility Function:	
Implementation Phase:		Implementation Date:	
Official Responsible:			
Notes:	Two - way intersection corners C,D

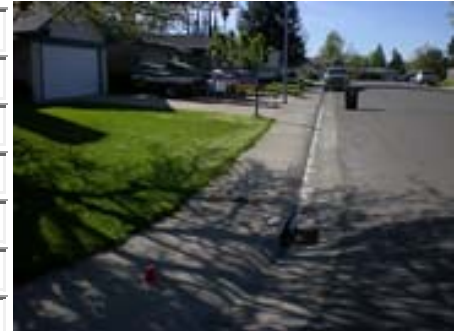
Field Date:	4/4/2011	Report Date:	4/4/2011	Barrier #:	6539A
Location:	Escallonia Dr - East				
X Coordinate:	-121.25191				
Y Coordinate:	38.6968				
Barrier Area:	Sidewalks				
Barrier Type:	Cross Slope - Existing (5.0% or more)				
Code Ref:	CBC 1133B.7.1.3 and ADA/ABA 403.3

As Built Meas:	1006	Quantity:	LF
Description:	Cross slope exceeds 2.0% (5.0% or more)		
As Built Desc:	5.2% cross slope		
Solution:	Demolish existing and construct new route		
Bar. Severity:	1 Necessary	Cost Estimate:	\$125,750.00
Implementation Priority:	4	Facility Function:	
Implementation Phase:		Implementation Date:	
Official Responsible:

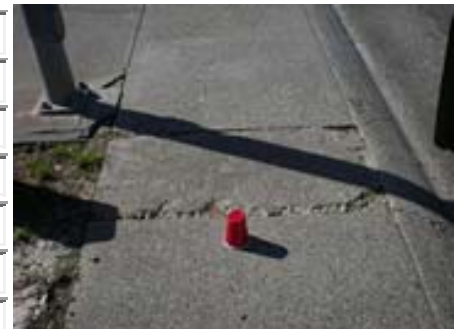
Field Date:	4/4/2011	Report Date:	4/4/2011	Barrier #:	6540
Location:	Escallonia Dr - East				
X Coordinate:	-121.25237				
Y Coordinate:	38.69458				
Barrier Area:	Sidewalks				
Barrier Type:	Surface Condition - Damaged				
Code Ref:	CBC 1133B.7.1 and ADA/ABA 302.1

As Built Meas:	4	Quantity:	LF
Description:	Surface is not firm and stable (cracked, broken or loose soil, etc.)		
As Built Desc:	Cracked concrete		
Solution:	Repair surface to make firm and stable		
Bar. Severity:	1 Necessary	Cost Estimate:	\$500.00
Implementation Priority:	4	Facility Function:	
Implementation Phase:		Implementation Date:	
Official Responsible:

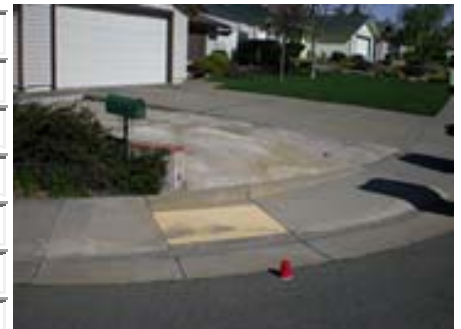
Field Date:	4/4/2011	Report Date:	4/4/2011	Barrier #:	6542B
Location:	Beckwith Wy - North				
X Coordinate:	-121.2521				
Y Coordinate:	38.69435				
Barrier Area:	Sidewalks				
Barrier Type:	Surface Condition - Damaged				
Code Ref:	CBC 1133B.7.1 and ADA/ABA 302.1

As Built Meas:	8	Quantity:	LF
Description:	Surface is not firm and stable (cracked, broken or loose soil, etc.)		
As Built Desc:	Cracked concrete		
Solution:	Repair surface to make firm and stable		
Bar. Severity:	1 Necessary	Cost Estimate:	\$1,000.00
Implementation Priority:	4	Facility Function:	
Implementation Phase:		Implementation Date:	
Official Responsible:			
Notes:

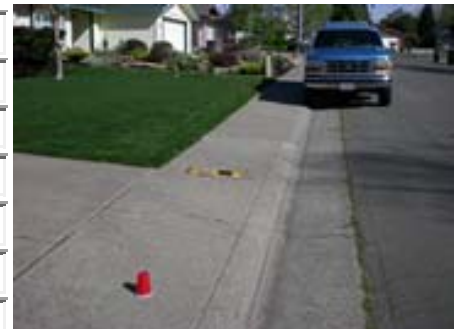
Field Date:	4/4/2011	Report Date:	4/4/2011	Barrier #:	6544A
Location:	Hatfield Ct - West				
X Coordinate:	-121.25168				
Y Coordinate:	38.69441				
Barrier Area:	Sidewalks				
Barrier Type:	Cross Slope - Existing (4.1% to 4.9%)				
Code Ref:	CBC 1133B.7.1.3 and ADA/ABA 403.3

As Built Meas:	357	Quantity:	LF
Description:	Cross slope exceeds 2.0% (4.1% to 4.9%)		
As Built Desc:	4.2% cross slope		
Solution:	Demolish existing and construct new route		
Bar. Severity:	2 Recommended	Cost Estimate:	\$44,625.00
Implementation Priority:	4	Facility Function:	
Implementation Phase:		Implementation Date:	
Official Responsible:			
Notes:

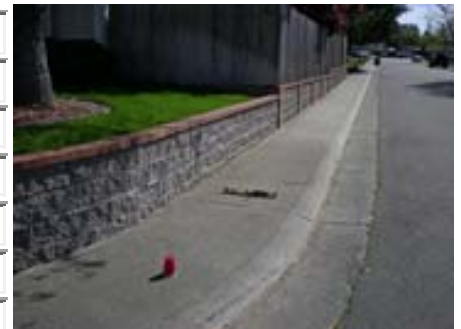
Field Date:	4/4/2011	Report Date:	4/4/2011	Barrier #:	6546
Location:	Beckwith Wy - North				
X Coordinate:	-121.25137				
Y Coordinate:	38.69435				
Barrier Area:	Sidewalks				
Barrier Type:	Cross Slope - Existing (3.1% to 4.0%)				
Code Ref:	CBC 1133B.7.1.3 and ADA/ABA 403.3

As Built Meas:	495	Quantity:	LF
Description:	Cross slope exceeds 2.0% (3.1% to 4.0%)		
As Built Desc:	3.9% cross slope		
Solution:	Demolish existing and construct new route		
Bar. Severity:	3 Hindrance	Cost Estimate:	\$61,875.00
Implementation Priority:	4	Facility Function:	
Implementation Phase:		Implementation Date:	
Official Responsible:			
Notes:

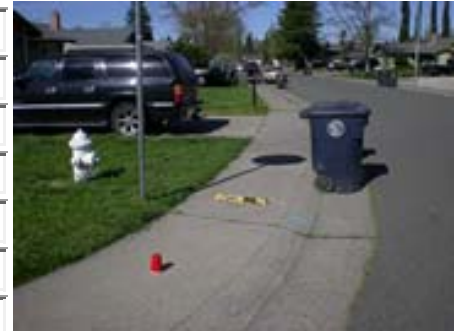
Barrier Type: Cross Slope - Existing (4.1% to 4.9%)

Code Ref: CBC 1133B.7.1.3 and ADA/ABA 403.3

As Built Meas: 748 Quantity: LF

Description: Cross slope exceeds 2.0% (4.1% to 4.9%)

Bar. Severity: 2 Recommended Cost Estimate: \$93,500.00 Status:

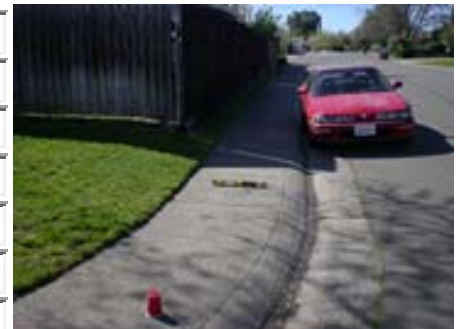
Barrier Type: Cross Slope - Existing (4.1% to 4.9%)

Code Ref: CBC 1133B.7.1.3 and ADA/ABA 403.3

As Built Meas: 200 Quantity: LF

Description: Cross slope exceeds 2.0% (4.1% to 4.9%)

Bar. Severity: 2 Recommended Cost Estimate: \$25,000.00 Status:

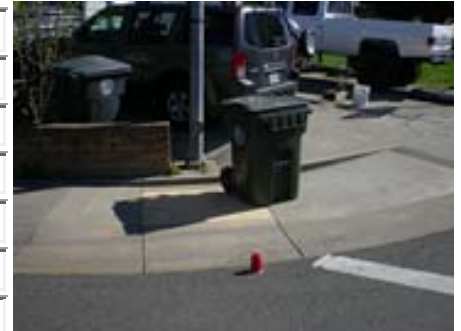
Field Date:	4/4/2011	Report Date:	4/4/2011	Barrier #:	6549
Location:	Escallonia Dr and Cranford Wy - Corner B				
X Coordinate:	-121.25241				
Y Coordinate:	38.69362				
Barrier Area:	Curb Ramps				
Barrier Type:	12" Grooves - Existing (3.1% to 4.0%)				
Code Ref:	CBC 1127B.5.6

As Built Meas:	1	Quantity:	EACH
Description:	12" grooves at top of curb ramp are not level (3.1% to 4.0%)		
As Built Desc:	3.1% at 12" grooves		
Solution:	Demolish existing and construct new curb ramp		
Bar. Severity:	3 Hindrance	Cost Estimate:	\$2,500.00
Implementation Priority:	4	Facility Function:	
Implementation Phase:		Implementation Date:	
Official Responsible:			
Notes:	Two - way intersection corners B,C

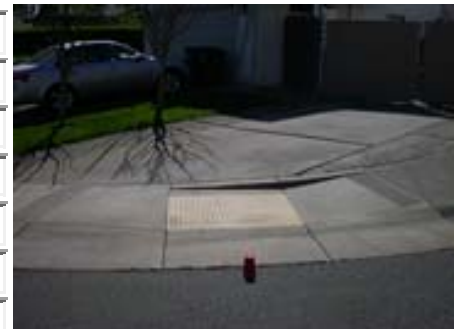
Field Date:	4/4/2011	Report Date:	4/4/2011	Barrier #:	6550A
Location:	Escallonia Dr and Cranford Wy - Corner C				
X Coordinate:	-121.25243				
Y Coordinate:	38.69348				
Barrier Area:	Curb Ramps				
Barrier Type:	12" Grooves - Existing (>5.0%)				
Code Ref:	CBC 1127B.5.6

As Built Meas:	1	Quantity:	EACH
Description:	12" grooves at top of curb ramp are not level (>5.0%)		
As Built Desc:	6.2% at 12" grooves		
Solution:	Demolish existing and construct new curb ramp		
Bar. Severity:	1 Necessary	Cost Estimate:	\$2,500.00
Implementation Priority:	4	Facility Function:	
Implementation Phase:		Implementation Date:	
Official Responsible:			
Notes:	Two - way intersection corners B,C

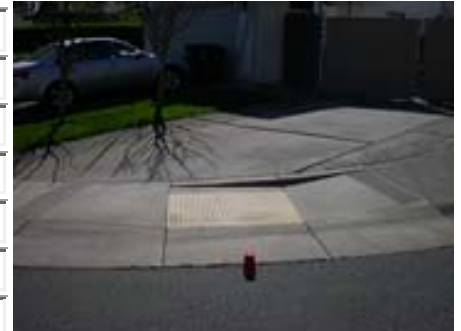
Field Date:	4/4/2011	Report Date:	4/4/2011	Barrier #:	6550B
Location:	Escallonia Dr and Cranford Wy - Corner C				
X Coordinate:	-121.25243				
Y Coordinate:	38.69348				
Barrier Area:	Curb Ramps				
Barrier Type:	Running Slope - New Construction				
Code Ref:	CBC 1127B.5.3 and ADA/ABA 406.2

As Built Meas:	1	Quantity:	EACH
Description:	Ramp run cross slope exceeds 2.0%		
As Built Desc:	10.4% running slope		
Solution:	Demolish existing and construct new curb ramp		
Bar. Severity:	1 Necessary	Cost Estimate:	\$0.00
Implementation Priority:	4	Facility Function:	
Implementation Phase:		Implementation Date:	
Official Responsible:			
Notes:	Two - way intersection corners B,C

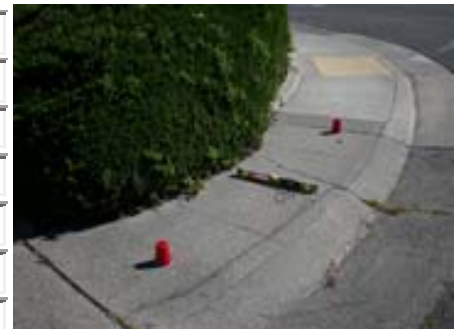
Field Date:	4/4/2011	Report Date:	4/4/2011	Barrier #:	6551A
Location:	Cranford Wy - North				
X Coordinate:	-121.25205				
Y Coordinate:	38.69362				
Barrier Area:	Sidewalks				
Barrier Type:	Cross Slope - Existing (3.1% to 4.0%)				
Code Ref:	CBC 1133B.7.1.3 and ADA/ABA 403.3

As Built Meas:	720	Quantity:	LF
Description:	Cross slope exceeds 2.0% (3.1% to 4.0%)		
As Built Desc:	3.8% cross slope		
Solution:	Demolish existing and construct new route		
Bar. Severity:	3 Hindrance	Cost Estimate:	\$90,000.00
Implementation Priority:	4	Facility Function:	
Implementation Phase:		Implementation Date:	
Official Responsible:			
Notes:

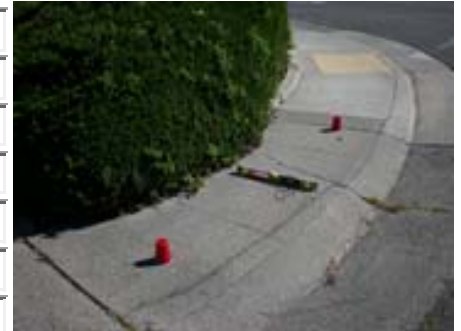
Field Date:	4/4/2011	Report Date:	4/4/2011	Barrier #:	6551B
Location:	Cranford Wy - North				
X Coordinate:	-121.24988				
Y Coordinate:	38.69359				
Barrier Area:	Sidewalks				
Barrier Type:	Clear Width - Existing ($\leq 31"$ or less)				
Code Ref:	CBC 1133B.7.1

As Built Meas:	9	Quantity:	LF
Description:	Pedestrian route is not min. 48" wide ($\leq 31"$ or less)		
As Built Desc:	24" clear width		
Solution:	Demolish existing and construct new route		
Bar. Severity:	1 Necessary	Cost Estimate:	\$1,125.00
Implementation Priority:	4	Facility Function:	
Implementation Phase:		Implementation Date:	
Official Responsible:			
Notes:

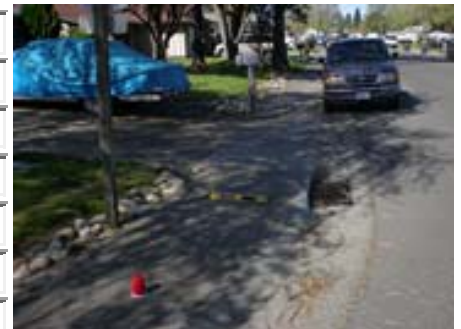
Field Date:	4/4/2011	Report Date:	4/4/2011	Barrier #:	6552
Location:	Cranford Wy - South				
X Coordinate:	-121.24986				
Y Coordinate:	38.69351				
Barrier Area:	Sidewalks				
Barrier Type:	Cross Slope - Existing (4.1% to 4.9%)				
Code Ref:	CBC 1133B.7.1.3 and ADA/ABA 403.3

As Built Meas:	717	Quantity:	LF
Description:	Cross slope exceeds 2.0% (4.1% to 4.9%)		
As Built Desc:	4.1% cross slope		
Solution:	Demolish existing and construct new route		
Bar. Severity:	2 Recommended	Cost Estimate:	\$89,625.00
Implementation Priority:	4	Facility Function:	
Implementation Phase:		Implementation Date:	
Official Responsible:			
Notes:

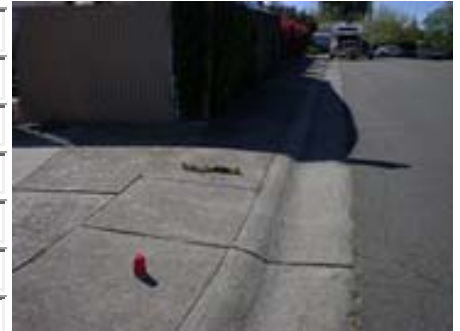
Field Date:	4/4/2011	Report Date:	4/4/2011	Barrier #:	6553
Location:	Escallonia Dr - East				
X Coordinate:	-121.25242				
Y Coordinate:	38.69345				
Barrier Area:	Sidewalks				
Barrier Type:	Cross Slope - Existing (3.1% to 4.0%)				
Code Ref:	CBC 1133B.7.1.3 and ADA/ABA 403.3

As Built Meas:	103	Quantity:	LF
Description:	Cross slope exceeds 2.0% (3.1% to 4.0%)		
As Built Desc:	3.6% cross slope		
Solution:	Demolish existing and construct new route		
Bar. Severity:	3 Hindrance	Cost Estimate:	\$12,875.00
Implementation Priority:	4	Facility Function:	
Implementation Phase:		Implementation Date:	
Official Responsible:

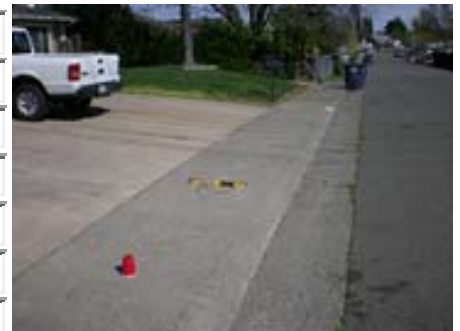
Field Date:	4/4/2011	Report Date:	4/4/2011	Barrier #:	6554
Location:	Escallonia Dr - West				
X Coordinate:	-121.2526				
Y Coordinate:	38.69318				
Barrier Area:	Sidewalks				
Barrier Type:	Cross Slope - Existing (4.1% to 4.9%)				
Code Ref:	CBC 1133B.7.1.3 and ADA/ABA 403.3

As Built Meas:	441	Quantity:	LF
Description:	Cross slope exceeds 2.0% (4.1% to 4.9%)		
As Built Desc:	4.6% cross slope		
Solution:	Demolish existing and construct new route		
Bar. Severity:	2 Recommended	Cost Estimate:	\$55,125.00
Implementation Priority:	4	Facility Function:	
Implementation Phase:		Implementation Date:	
Official Responsible:

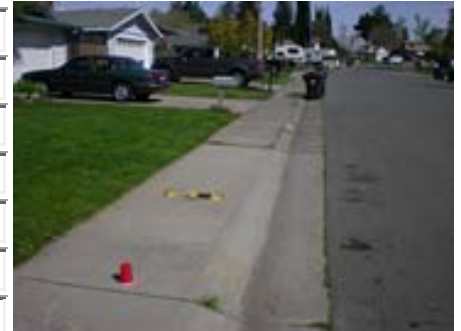
Field Date:	4/4/2011	Report Date:	4/4/2011	Barrier #:	6555
Location:	Escallonia Dr - West				
X Coordinate:	-121.2526				
Y Coordinate:	38.69446				
Barrier Area:	Sidewalks				
Barrier Type:	Cross Slope - Existing (5.0% or more)				
Code Ref:	CBC 1133B.7.1.3 and ADA/ABA 403.3

As Built Meas:	166	Quantity:	LF
Description:	Cross slope exceeds 2.0% (5.0% or more)		
As Built Desc:	6.3% cross slope		
Solution:	Demolish existing and construct new route		
Bar. Severity:	1 Necessary	Cost Estimate:	\$20,750.00
Implementation Priority:	4	Facility Function:	
Implementation Phase:		Implementation Date:	
Official Responsible:

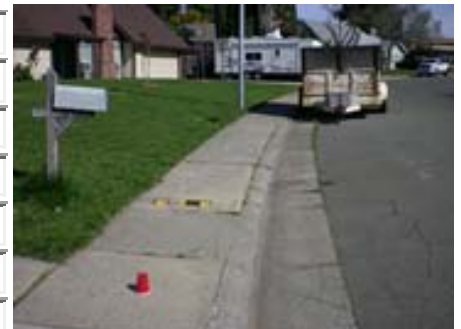
Field Date:	4/4/2011	Report Date:	4/4/2011	Barrier #:	6556A
Location:	Escallonia Dr - West				
X Coordinate:	-121.25261				
Y Coordinate:	38.69503				
Barrier Area:	Sidewalks				
Barrier Type:	Cross Slope - Existing (3.1% to 4.0%)				
Code Ref:	CBC 1133B.7.1.3 and ADA/ABA 403.3

As Built Meas:	386	Quantity:	LF
Description:	Cross slope exceeds 2.0% (3.1% to 4.0%)		
As Built Desc:	4.0% cross slope		
Solution:	Demolish existing and construct new route		
Bar. Severity:	3 Hindrance	Cost Estimate:	\$48,250.00
Implementation Priority:	4	Facility Function:	
Implementation Phase:		Implementation Date:	
Official Responsible:

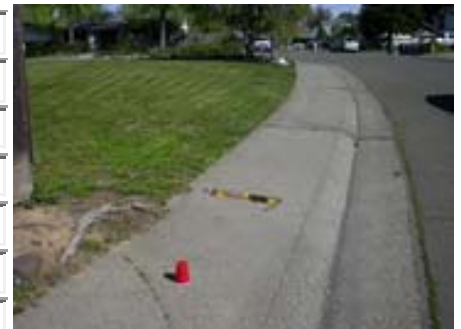
Field Date:	4/4/2011	Report Date:	4/4/2011	Barrier #:	6557
Location:	Escallonia Dr - West				
X Coordinate:	-121.252				
Y Coordinate:	38.69601				
Barrier Area:	Sidewalks				
Barrier Type:	Cross Slope - Existing (4.1% to 4.9%)				
Code Ref:	CBC 1133B.7.1.3 and ADA/ABA 403.3

As Built Meas:	84	Quantity:	LF
Description:	Cross slope exceeds 2.0% (4.1% to 4.9%)		
As Built Desc:	4.4% cross slope		
Solution:	Demolish existing and construct new route		
Bar. Severity:	2 Recommended	Cost Estimate:	\$10,500.00
Implementation Priority:	4	Facility Function:	
Implementation Phase:		Implementation Date:	
Official Responsible:			
Notes:

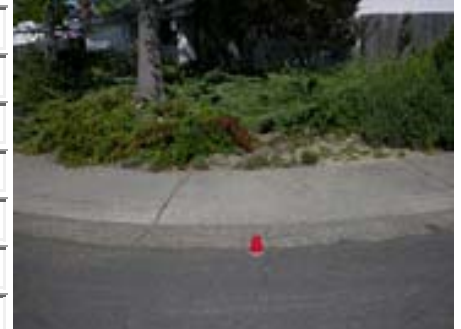
Field Date:	4/4/2011	Report Date:	4/4/2011	Barrier #:	6558
Location:	Escallonia Dr and Burnside Ct - Corner A				
X Coordinate:	-121.25205				
Y Coordinate:	38.69638				
Barrier Area:	Curb Ramps				
Barrier Type:	No Curb Ramp - Depressed Existing Curb				
Code Ref:	CBC 1127B.5.1 and ADA/ABA 402.2

As Built Meas:	1	Quantity:	EACH
Description:	No compliant curb cut at corner (intersection)		
As Built Desc:	10.5% running slope at depressed area		
Solution:	Demolish existing and construct curb cut		
Bar. Severity:	1 Necessary	Cost Estimate:	\$2,500.00
Implementation Priority:	4	Facility Function:	
Implementation Phase:		Implementation Date:	
Official Responsible:

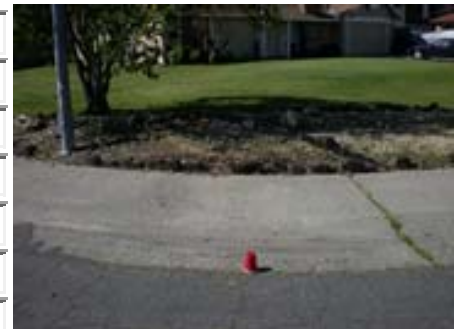
Field Date:	4/4/2011	Report Date:	4/4/2011	Barrier #:	6559
Location:	Escallonia Dr and Burnside Ct - Corner D				
X Coordinate:	-121.25202				
Y Coordinate:	38.69625				
Barrier Area:	Curb Ramps				
Barrier Type:	No Curb Ramp - Depressed Existing Curb				
Code Ref:	CBC 1127B.5.1 and ADA/ABA 402.2

As Built Meas:	1	Quantity:	EACH
Description:	No compliant curb cut at corner (intersection)		
As Built Desc:	10.7% running slope at depressed area		
Solution:	Demolish existing and construct curb cut		
Bar. Severity:	1 Necessary	Cost Estimate:	\$2,500.00
Implementation Priority:	4	Facility Function:	
Implementation Phase:		Implementation Date:	
Official Responsible:

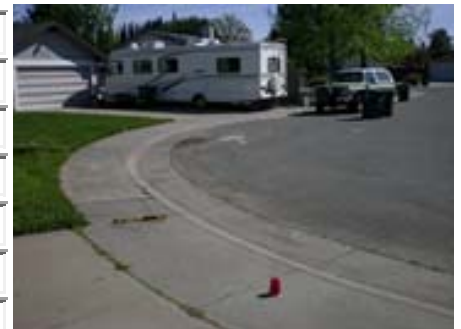
Field Date:	4/4/2011	Report Date:	4/4/2011	Barrier #:	6561
Location:	Burnside Ct - South				
X Coordinate:	-121.25259				
Y Coordinate:	38.69633				
Barrier Area:	Sidewalks				
Barrier Type:	Cross Slope - Existing (4.1% to 4.9%)				
Code Ref:	CBC 1133B.7.1.3 and ADA/ABA 403.3

As Built Meas:	175	Quantity:	LF
Description:	Cross slope exceeds 2.0% (4.1% to 4.9%)		
As Built Desc:	4.1% cross slope		
Solution:	Demolish existing and construct new route		
Bar. Severity:	2 Recommended	Cost Estimate:	\$21,875.00
Implementation Priority:	4	Facility Function:	
Implementation Phase:		Implementation Date:	
Official Responsible:

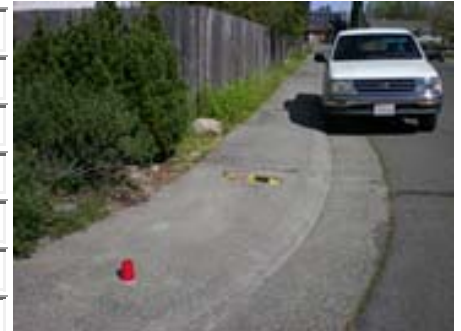
Field Date:	4/4/2011	Report Date:	4/4/2011	Barrier #:	6562
Location:	Escallonia Dr - West				
X Coordinate:	-121.25202				
Y Coordinate:	38.6964				
Barrier Area:	Sidewalks				
Barrier Type:	Cross Slope - Existing (3.1% to 4.0%)				
Code Ref:	CBC 1133B.7.1.3 and ADA/ABA 403.3

As Built Meas:	215	Quantity:	LF
Description:	Cross slope exceeds 2.0% (3.1% to 4.0%)		
As Built Desc:	4.0% cross slope		
Solution:	Demolish existing and construct new route		
Bar. Severity:	3 Hindrance	Cost Estimate:	\$26,875.00
Implementation Priority:	4	Facility Function:	
Implementation Phase:		Implementation Date:	
Official Responsible:

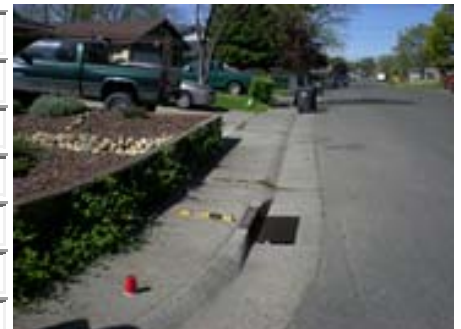
Field Date:	4/4/2011	Report Date:	4/4/2011	Barrier #:	6563
Location:	Streng Ave - South				
X Coordinate:	-121.25222				
Y Coordinate:	38.69702				
Barrier Area:	Sidewalks				
Barrier Type:	Cross Slope - Existing (5.0% or more)				
Code Ref:	CBC 1133B.7.1.3 and ADA/ABA 403.3

As Built Meas:	395	Quantity:	LF
Description:	Cross slope exceeds 2.0% (5.0% or more)		
As Built Desc:	5.0% cross slope		
Solution:	Demolish existing and construct new route		
Bar. Severity:	1 Necessary	Cost Estimate:	\$49,375.00
Implementation Priority:	4	Facility Function:	
Implementation Phase:		Implementation Date:	
Official Responsible:

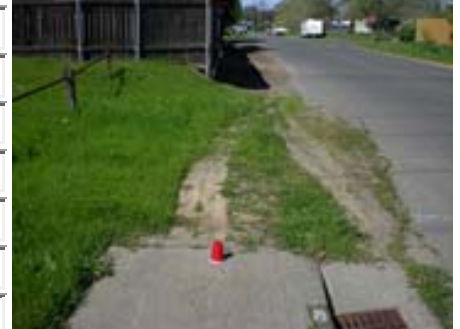
Field Date:	4/4/2011	Report Date:	4/4/2011	Barrier #:	6564
Location:	Streng Ave - South				
X Coordinate:	-121.25361				
Y Coordinate:	38.69702				
Barrier Area:	Sidewalks				
Barrier Type:	No Sidewalk - No Barricade				
Code Ref:	MUTCD Section 6D.01

As Built Meas:	1	Quantity:	JOB
Description:	No barricade provided where sidewalk ends in hazardous location		
As Built Desc:	No barricade or other warning provided for the visually impaired at end of sidewalk		
Solution:	Provide barricade with cane detectable warning at end of sidewalk		
Bar. Severity:	1 Necessary	Cost Estimate:	\$1,350.00
Implementation Priority:	4	Facility Function:	
Implementation Phase:		Implementation Date:	
Official Responsible:

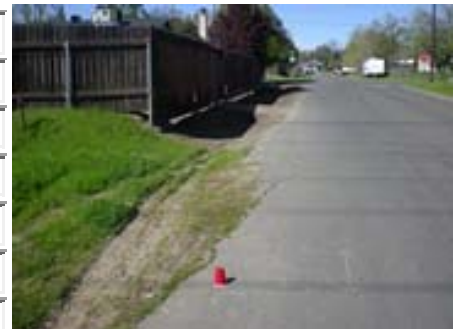
Field Date:	4/4/2011	Report Date:	4/4/2011	Barrier #:	6565
Location:	Streng Ave - South				
X Coordinate:	-121.25362				
Y Coordinate:	38.69704				
Barrier Area:	Sidewalks				
Barrier Type:	No sidewalk				
Code Ref:	CBC 1127B.1 and ADA/ABA 206.2.1

As Built Meas:	165	Quantity:	LF
Description:	No pedestrian route provided		
As Built Desc:	No sidewalk provided		
Solution:	Construct new firm and stable pedestrian route		
Bar. Severity:	1 Necessary	Cost Estimate:	\$16,500.00
Implementation Priority:	4	Facility Function:	
Implementation Phase:		Implementation Date:	
Official Responsible:

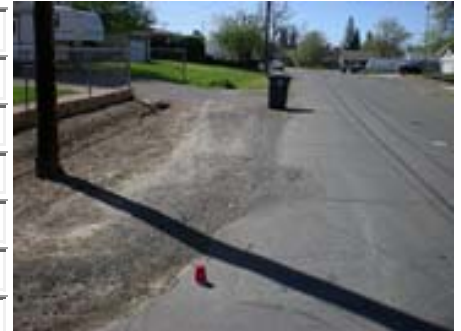
Field Date:	4/4/2011	Report Date:	4/4/2011	Barrier #:	6566
Location:	Melva St - East				
X Coordinate:	-121.25415				
Y Coordinate:	38.69695				
Barrier Area:	Sidewalks				
Barrier Type:	No sidewalk				
Code Ref:	CBC 1127B.1 and ADA/ABA 206.2.1

As Built Meas:	145	Quantity:	LF
Description:	No pedestrian route provided		
As Built Desc:	No sidewalk provided		
Solution:	Construct new firm and stable pedestrian route		
Bar. Severity:	1 Necessary	Cost Estimate:	\$14,500.00
Implementation Priority:	4	Facility Function:	
Implementation Phase:		Implementation Date:	
Official Responsible:			
Notes:

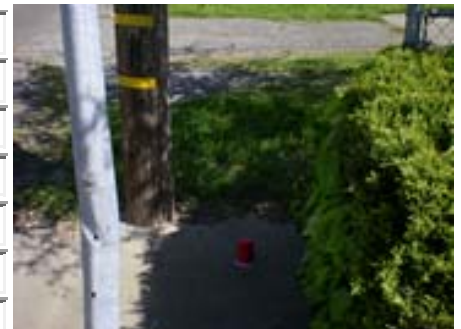
Field Date:	4/4/2011	Report Date:	4/4/2011	Barrier #:	6567
Location:	Melva St - East				
X Coordinate:	-121.25409				
Y Coordinate:	38.69657				
Barrier Area:	Sidewalks				
Barrier Type:	No Sidewalk - No Barricade				
Code Ref:	MUTCD Section 6D.01

As Built Meas:	1	Quantity:	JOB
Description:	No barricade provided where sidewalk ends in hazardous location		
As Built Desc:	No barricade or other warning provided for the visually impaired at end of sidewalk		
Solution:	Provide barricade with cane detectable warning at end of sidewalk		
Bar. Severity:	1 Necessary	Cost Estimate:	\$1,350.00
Implementation Priority:	4	Facility Function:	
Implementation Phase:		Implementation Date:	
Official Responsible:			
Notes:

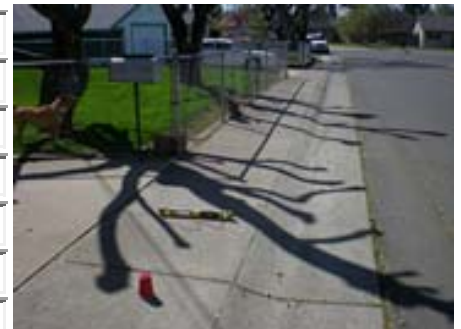
Field Date:	4/4/2011	Report Date:	4/4/2011	Barrier #:	6569
Location:	Melva St - East				
X Coordinate:	-121.25414				
Y Coordinate:	38.69644				
Barrier Area:	Sidewalks				
Barrier Type:	Cross Slope - Existing (4.1% to 4.9%)				
Code Ref:	CBC 1133B.7.1.3 and ADA/ABA 403.3

As Built Meas:	149	Quantity:	LF
Description:	Cross slope exceeds 2.0% (4.1% to 4.9%)		
As Built Desc:	4.3% cross slope		
Solution:	Demolish existing and construct new route		
Bar. Severity:	2 Recommended	Cost Estimate:	\$18,625.00
Implementation Priority:	4	Facility Function:	
Implementation Phase:		Implementation Date:	
Official Responsible:

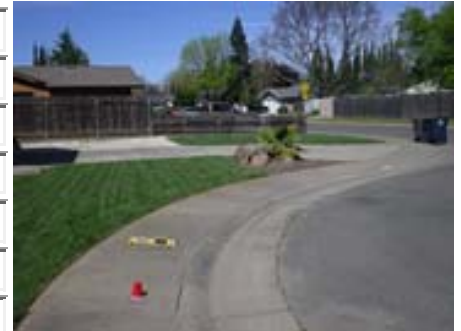
Field Date:	4/4/2011	Report Date:	4/4/2011	Barrier #:	6570
Location:	Prime Wy - South				
X Coordinate:	-121.25431				
Y Coordinate:	38.69594				
Barrier Area:	Sidewalks				
Barrier Type:	Cross Slope - Existing (3.1% to 4.0%)				
Code Ref:	CBC 1133B.7.1.3 and ADA/ABA 403.3

As Built Meas:	455	Quantity:	LF
Description:	Cross slope exceeds 2.0% (3.1% to 4.0%)		
As Built Desc:	3.4% cross slope		
Solution:	Demolish existing and construct new route		
Bar. Severity:	3 Hindrance	Cost Estimate:	\$56,875.00
Implementation Priority:	4	Facility Function:	
Implementation Phase:		Implementation Date:	
Official Responsible:

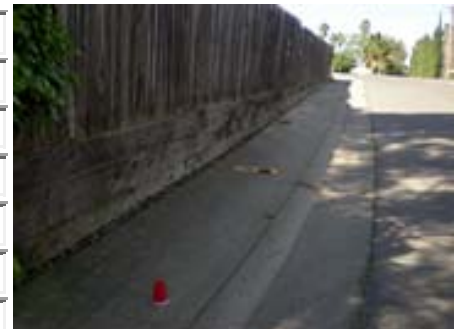
Field Date:	4/4/2011	Report Date:	4/4/2011	Barrier #:	6571
Location:	Prime Wy - South				
X Coordinate:	-121.25745				
Y Coordinate:	38.69603				
Barrier Area:	Sidewalks				
Barrier Type:	Cross Slope - Existing (3.1% to 4.0%)				
Code Ref:	CBC 1133B.7.1.3 and ADA/ABA 403.3

As Built Meas:	110	Quantity:	LF
Description:	Cross slope exceeds 2.0% (3.1% to 4.0%)		
As Built Desc:	3.8% cross slope		
Solution:	Demolish existing and construct new route		
Bar. Severity:	3 Hindrance	Cost Estimate:	\$13,750.00
Implementation Priority:	4	Facility Function:	
Implementation Phase:		Implementation Date:	
Official Responsible:

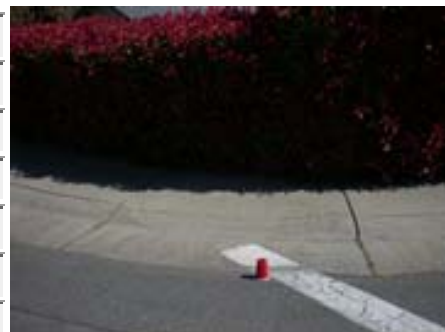
Field Date:	4/4/2011	Report Date:	4/4/2011	Barrier #:	6572
Location:	Prime Wy and Cross Dr - Corner B				
X Coordinate:	-121.25793				
Y Coordinate:	38.69617				
Barrier Area:	Curb Ramps				
Barrier Type:	No Curb Ramp - Depressed Existing Curb				
Code Ref:	CBC 1127B.5.1 and ADA/ABA 402.2

As Built Meas:	1	Quantity:	EACH
Description:	No compliant curb cut at corner (intersection)		
As Built Desc:	12.4% running slope at depressed area		
Solution:	Demolish existing and construct curb cut		
Bar. Severity:	1 Necessary	Cost Estimate:	\$2,500.00
Implementation Priority:	4	Facility Function:	
Implementation Phase:		Implementation Date:	
Official Responsible:			
Notes:	Two - way intersection corners B,C

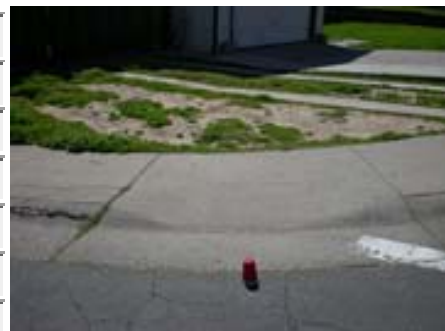
Field Date:	4/4/2011	Report Date:	4/4/2011	Barrier #:	6573
Location:	Prime Wy and Cross Dr - Corner C				
X Coordinate:	-121.25791				
Y Coordinate:	38.69607				
Barrier Area:	Curb Ramps				
Barrier Type:	No Curb Ramp - Depressed Existing Curb				
Code Ref:	CBC 1127B.5.1 and ADA/ABA 402.2

As Built Meas:	1	Quantity:	EACH
Description:	No compliant curb cut at corner (intersection)		
As Built Desc:	12.7% running slope at depressed area		
Solution:	Demolish existing and construct curb cut		
Bar. Severity:	1 Necessary	Cost Estimate:	\$2,500.00
Implementation Priority:	4	Facility Function:	
Implementation Phase:		Implementation Date:	
Official Responsible:			
Notes:	Two - way intersection corners B,C

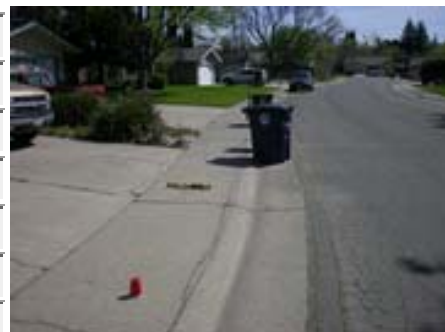
Field Date:	4/4/2011	Report Date:	4/4/2011	Barrier #:	6576A
Location:	Prime Wy - North				
X Coordinate:	-121.25566				
Y Coordinate:	38.69614				
Barrier Area:	Sidewalks				
Barrier Type:	Cross Slope - Existing (4.1% to 4.9%)				
Code Ref:	CBC 1133B.7.1.3 and ADA/ABA 403.3

As Built Meas:	380	Quantity:	LF
Description:	Cross slope exceeds 2.0% (4.1% to 4.9%)		
As Built Desc:	4.7% cross slope		
Solution:	Demolish existing and construct new route		
Bar. Severity:	2 Recommended	Cost Estimate:	\$47,500.00
Implementation Priority:	4	Facility Function:	
Implementation Phase:		Implementation Date:	
Official Responsible:			
Notes:

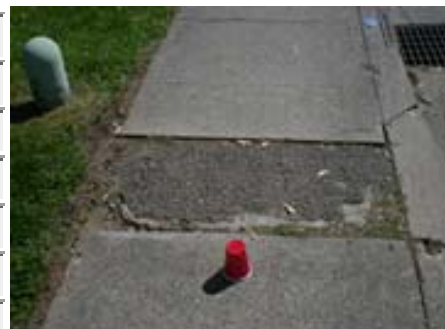
Field Date:	4/4/2011	Report Date:	4/4/2011	Barrier #:	6576B
Location:	Prime Wy - North				
X Coordinate:	-121.25533				
Y Coordinate:	38.69618				
Barrier Area:	Sidewalks				
Barrier Type:	Surface Condition - Damaged				
Code Ref:	CBC 1133B.7.1 and ADA/ABA 302.1

As Built Meas:	4	Quantity:	LF
Description:	Surface is not firm and stable (cracked, broken or loose soil, etc.)		
As Built Desc:	Cracked concrete		
Solution:	Repair surface to make firm and stable		
Bar. Severity:	1 Necessary	Cost Estimate:	\$500.00
Implementation Priority:	4	Facility Function:	
Implementation Phase:		Implementation Date:	
Official Responsible:			
Notes:

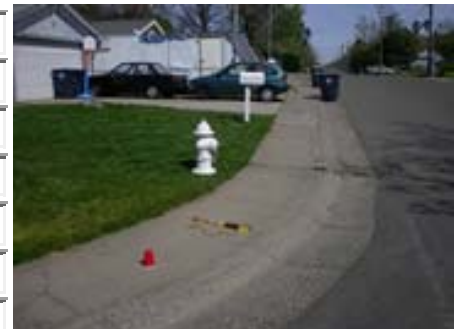
Field Date:	4/4/2011	Report Date:	4/4/2011	Barrier #:	6578
Location:	Melva St - West				
X Coordinate:	-121.25434				
Y Coordinate:	38.69621				
Barrier Area:	Sidewalks				
Barrier Type:	Cross Slope - Existing (3.1% to 4.0%)				
Code Ref:	CBC 1133B.7.1.3 and ADA/ABA 403.3

As Built Meas:	145	Quantity:	LF
Description:	Cross slope exceeds 2.0% (3.1% to 4.0%)		
As Built Desc:	3.5% cross slope		
Solution:	Demolish existing and construct new route		
Bar. Severity:	3 Hindrance	Cost Estimate:	\$18,125.00
Implementation Priority:	4	Facility Function:	
Implementation Phase:		Implementation Date:	
Official Responsible:			
Notes:
