DRAFT ADA TRANSITION PLAN UPDATE
NEIGHBORHOOD AREA 9 SONA
SEPTEMBER 20, 2011

CITY OF CITRUS HEIGHTS

The Sunrise Oaks Neighborhood Association (SONA)

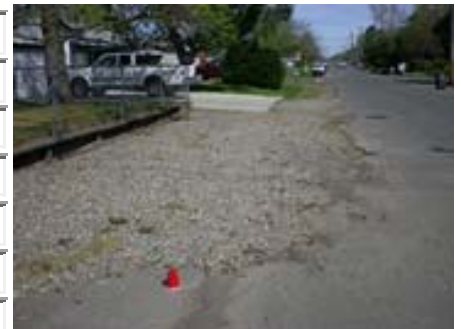
Field Date:	4/4/2011	Report Date:	4/4/2011	Barrier #:	6580
Location:	Melva St - West				
X Coordinate:	-121.25432				
Y Coordinate:	38.69661				
Barrier Area:	Sidewalks				
Barrier Type:	No sidewalk				
Code Ref:	CBC 1127B.1 and ADA/ABA 206.2.1

As Built Meas:	154	Quantity:	LF
Description:	No pedestrian route provided		
As Built Desc:	No sidewalk provided		
Solution:	Construct new firm and stable pedestrian route		
Bar. Severity:	1 Necessary	Cost Estimate:	\$15,400.00
Implementation Priority:	4	Facility Function:	
Implementation Phase:		Implementation Date:	
Official Responsible:			
Notes:

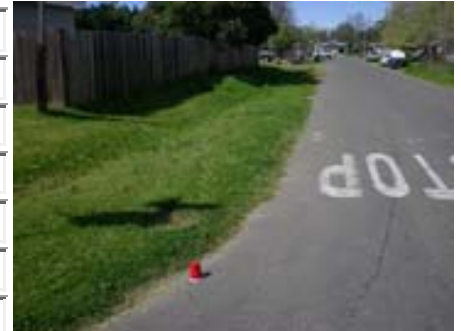
Field Date:	4/4/2011	Report Date:	4/4/2011	Barrier #:	6581
Location:	Streng Ave - South				
X Coordinate:	-121.25436				
Y Coordinate:	38.69707				
Barrier Area:	Sidewalks				
Barrier Type:	No sidewalk				
Code Ref:	CBC 1127B.1 and ADA/ABA 206.2.1

As Built Meas:	422	Quantity:	LF
Description:	No pedestrian route provided		
As Built Desc:	No sidewalk provided		
Solution:	Construct new firm and stable pedestrian route		
Bar. Severity:	1 Necessary	Cost Estimate:	\$42,200.00
Implementation Priority:	4	Facility Function:	
Implementation Phase:		Implementation Date:	
Official Responsible:			
Notes:

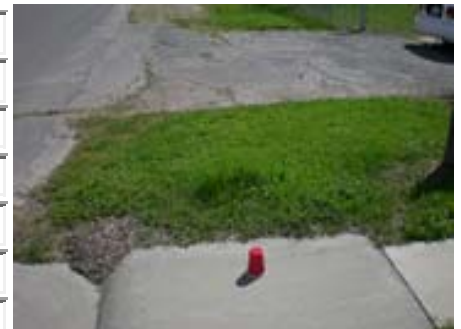
Field Date:	4/4/2011	Report Date:	4/4/2011	Barrier #:	6582
Location:	Streng Ave - South				
X Coordinate:	-121.25584				
Y Coordinate:	38.69705				
Barrier Area:	Sidewalks				
Barrier Type:	No Sidewalk - No Barricade				
Code Ref:	MUTCD Section 6D.01

As Built Meas:	1	Quantity:	JOB
Description:	No barricade provided where sidewalk ends in hazardous location		
As Built Desc:	No barricade or other warning provided for the visually impaired at end of sidewalk		
Solution:	Provide barricade with cane detectable warning at end of sidewalk		
Bar. Severity:	1 Necessary	Cost Estimate:	\$1,350.00
Implementation Priority:	4	Facility Function:	
Implementation Phase:		Implementation Date:	
Official Responsible:			
Notes:

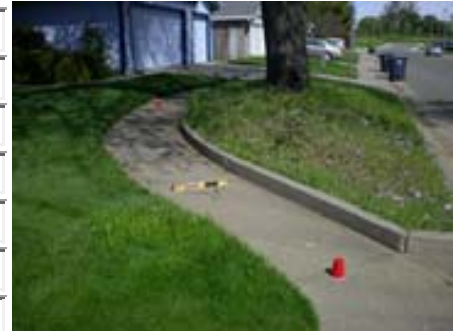
Field Date:	4/4/2011	Report Date:	4/4/2011	Barrier #:	6583A
Location:	Streng Ave - West				
X Coordinate:	-121.25651				
Y Coordinate:	38.69759				
Barrier Area:	Sidewalks				
Barrier Type:	Cross Slope - Existing (3.1% to 4.0%)				
Code Ref:	CBC 1133B.7.1.3 and ADA/ABA 403.3

As Built Meas:	59	Quantity:	LF
Description:	Cross slope exceeds 2.0% (3.1% to 4.0%) and running slope exceeds 5.0%		
As Built Desc:	3.9% cross slope, 6.2% running slope		
Solution:	Demolish existing and construct new route		
Bar. Severity:	1 Necessary	Cost Estimate:	\$7,375.00
Implementation Priority:	4	Facility Function:	
Implementation Phase:		Implementation Date:	
Official Responsible:			
Notes:

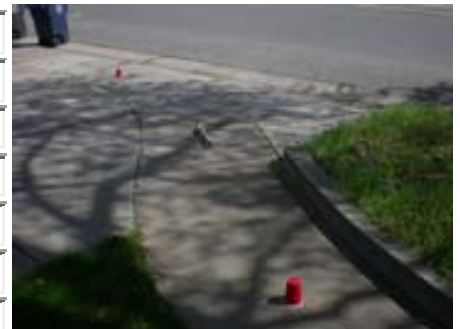
Field Date:	4/4/2011	Report Date:	4/4/2011	Barrier #:	6583B
Location:	Streng Ave - West				
X Coordinate:	-121.25647				
Y Coordinate:	38.69769				
Barrier Area:	Sidewalks				
Barrier Type:	Running Slope (New Construction)				
Code Ref:	CBC 1133B.7.3 and ADA/ABA 403.3

As Built Meas:	20	Quantity:	LF
Description:	Running slope exceeds 5.0% where roadway slope does not		
As Built Desc:	7.6% running slope		
Solution:	Demolish existing and construct new route		
Bar. Severity:	1 Necessary	Cost Estimate:	\$2,500.00
Implementation Priority:	4	Facility Function:	
Implementation Phase:		Implementation Date:	
Official Responsible:			
Notes:

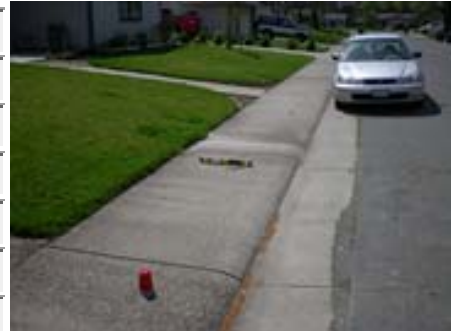
Field Date:	4/4/2011	Report Date:	4/4/2011	Barrier #:	6584
Location:	Streng Ave - East				
X Coordinate:	-121.25628				
Y Coordinate:	38.69825				
Barrier Area:	Sidewalks				
Barrier Type:	Cross Slope - Existing (3.1% to 4.0%)				
Code Ref:	CBC 1133B.7.1.3 and ADA/ABA 403.3

As Built Meas:	329	Quantity:	LF
Description:	Cross slope exceeds 2.0% (3.1% to 4.0%)		
As Built Desc:	3.5% cross slope		
Solution:	Demolish existing and construct new route		
Bar. Severity:	3 Hindrance	Cost Estimate:	\$41,125.00
Implementation Priority:	4	Facility Function:	
Implementation Phase:		Implementation Date:	
Official Responsible:

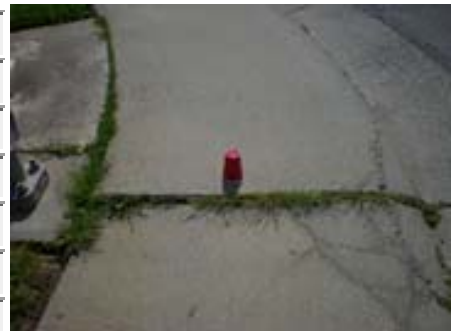
Field Date:	4/4/2011	Report Date:	4/4/2011	Barrier #:	6585
Location:	Streng Ave - East				
X Coordinate:	-121.25625				
Y Coordinate:	38.69715				
Barrier Area:	Sidewalks				
Barrier Type:	Abrupt Change in Level - > 1/2"				
Code Ref:	CBC 1133B.7.1 and ADA/ABA 303.3

As Built Meas:	4	Quantity:	LF
Description:	Change in level greater than 1/2"		
As Built Desc:	1/2" lip in sidewalk surface		
Solution:	Grind or repair sidewalk to remove trip hazard		
Bar. Severity:	1 Necessary	Cost Estimate:	\$1,000.00
Implementation Priority:	4	Facility Function:	
Implementation Phase:		Implementation Date:	
Official Responsible:

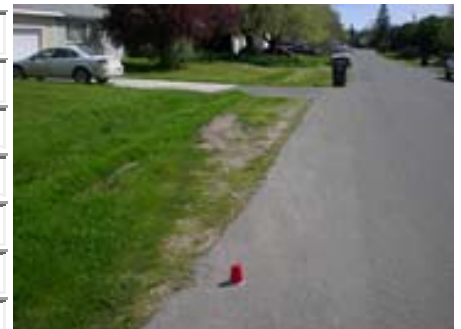
Field Date:	4/4/2011	Report Date:	4/4/2011	Barrier #:	6587
Location:	Streng Ave - North				
X Coordinate:	-121.2558				
Y Coordinate:	38.69707				
Barrier Area:	Sidewalks				
Barrier Type:	No sidewalk				
Code Ref:	CBC 1127B.1 and ADA/ABA 206.2.1

As Built Meas:	422	Quantity:	LF
Description:	No pedestrian route provided		
As Built Desc:	No sidewalk provided		
Solution:	Construct new firm and stable pedestrian route		
Bar. Severity:	1 Necessary	Cost Estimate:	\$42,200.00
Implementation Priority:	4	Facility Function:	
Implementation Phase:		Implementation Date:	
Official Responsible:

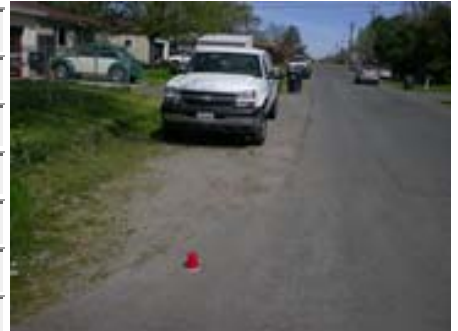
Field Date:	4/4/2011	Report Date:	4/4/2011	Barrier #:	6588
Location:	Melva St - West				
X Coordinate:	-121.25429				
Y Coordinate:	38.69719				
Barrier Area:	Sidewalks				
Barrier Type:	No sidewalk				
Code Ref:	CBC 1127B.1 and ADA/ABA 206.2.1

As Built Meas:	280	Quantity:	LF
Description:	No pedestrian route provided		
As Built Desc:	No sidewalk provided		
Solution:	Construct new firm and stable pedestrian route		
Bar. Severity:	1 Necessary	Cost Estimate:	\$28,000.00
Implementation Priority:	4	Facility Function:	
Implementation Phase:		Implementation Date:	
Official Responsible:

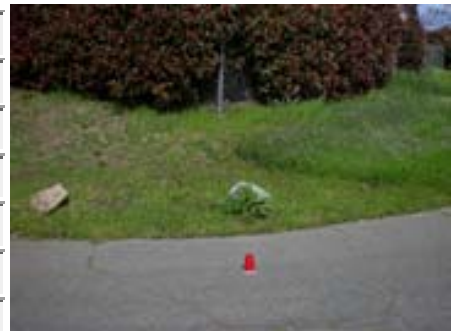
Field Date:	4/4/2011	Report Date:	4/4/2011	Barrier #:	6589
Location:	Melva St and Mandarin Cir - Corner A				
X Coordinate:	-121.25434				
Y Coordinate:	38.69805				
Barrier Area:	Blended Transitions				
Barrier Type:	Detectable Warnings - Truncated Domes				
Code Ref:	CBC 1127B.5.3

As Built Meas:	1	Quantity:	EACH
Description:	No truncated domes provided at transition into roadway		
As Built Desc:	No detectable warning provided		
Solution:	Provide compliant truncated domes		
Bar. Severity:	2 Recommended	Cost Estimate:	\$1,400.00
Implementation Priority:	4	Facility Function:	
Implementation Phase:		Implementation Date:	
Official Responsible:

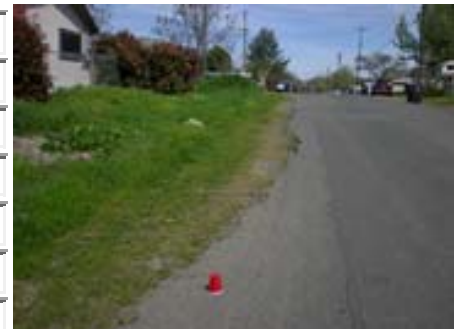
Field Date:	4/4/2011	Report Date:	4/4/2011	Barrier #:	6591
Location:	Melva St - West				
X Coordinate:	-121.2543				
Y Coordinate:	38.69809				
Barrier Area:	Sidewalks				
Barrier Type:	No sidewalk				
Code Ref:	CBC 1127B.1 and ADA/ABA 206.2.1

As Built Meas:	295	Quantity:	LF
Description:	No pedestrian route provided		
As Built Desc:	No sidewalk provided		
Solution:	Construct new firm and stable pedestrian route		
Bar. Severity:	1 Necessary	Cost Estimate:	\$29,500.00
Implementation Priority:	4	Facility Function:	
Implementation Phase:		Implementation Date:	
Official Responsible:			
Notes:

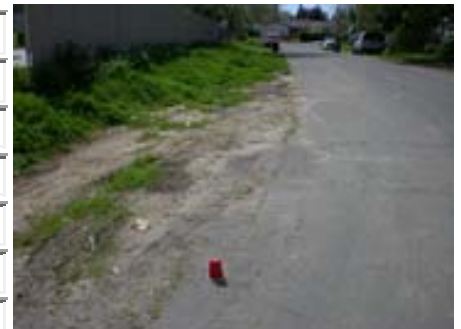
Field Date:	4/4/2011	Report Date:	4/4/2011	Barrier #:	6595
Location:	Mandarin Cir - East				
X Coordinate:	-121.25526				
Y Coordinate:	38.69887				
Barrier Area:	Sidewalks				
Barrier Type:	No sidewalk				
Code Ref:	CBC 1127B.1 and ADA/ABA 206.2.1

As Built Meas:	312	Quantity:	LF
Description:	No pedestrian route provided		
As Built Desc:	No sidewalk provided		
Solution:	Construct new firm and stable pedestrian route		
Bar. Severity:	1 Necessary	Cost Estimate:	\$31,200.00
Implementation Priority:	4	Facility Function:	
Implementation Phase:		Implementation Date:	
Official Responsible:

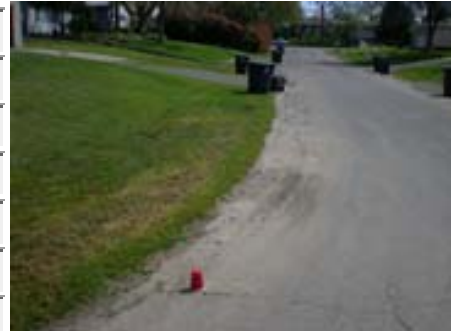
Field Date:	4/4/2011	Report Date:	4/4/2011	Barrier #:	6596
Location:	Mandarin Cir - North				
X Coordinate:	-121.25518				
Y Coordinate:	38.69805				
Barrier Area:	Sidewalks				
Barrier Type:	No sidewalk				
Code Ref:	CBC 1127B.1 and ADA/ABA 206.2.1

As Built Meas:	260	Quantity:	LF
Description:	No pedestrian route provided		
As Built Desc:	No sidewalk provided		
Solution:	Construct new firm and stable pedestrian route		
Bar. Severity:	1 Necessary	Cost Estimate:	\$26,000.00
Implementation Priority:	4	Facility Function:	
Implementation Phase:		Implementation Date:	
Official Responsible:

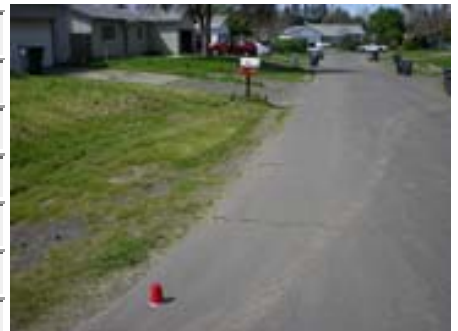
Field Date:	4/4/2011	Report Date:	4/4/2011	Barrier #:	6597
Location:	Mandarin Cir - South				
X Coordinate:	-121.25437				
Y Coordinate:	38.69795				
Barrier Area:	Sidewalks				
Barrier Type:	No sidewalk				
Code Ref:	CBC 1127B.1 and ADA/ABA 206.2.1

As Built Meas:	280	Quantity:	LF
Description:	No pedestrian route provided		
As Built Desc:	No sidewalk provided		
Solution:	Construct new firm and stable pedestrian route		
Bar. Severity:	1 Necessary	Cost Estimate:	\$28,000.00
Implementation Priority:	4	Facility Function:	
Implementation Phase:		Implementation Date:	
Official Responsible:

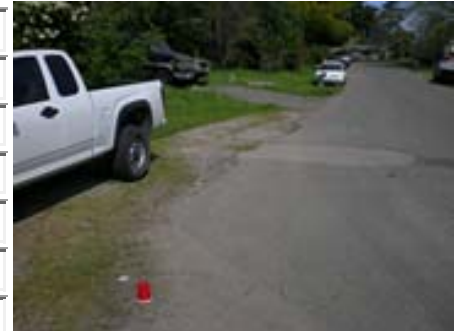
Field Date:	4/4/2011	Report Date:	4/4/2011	Barrier #:	6598
Location:	Mandarin Cir - North				
X Coordinate:	-121.25543				
Y Coordinate:	38.69806				
Barrier Area:	Sidewalks				
Barrier Type:	No sidewalk				
Code Ref:	CBC 1127B.1 and ADA/ABA 206.2.1

As Built Meas:	350	Quantity:	LF
Description:	No pedestrian route provided		
As Built Desc:	No sidewalk provided		
Solution:	Construct new firm and stable pedestrian route		
Bar. Severity:	1 Necessary	Cost Estimate:	\$35,000.00
		Status:	
Implementation Priority:	4	Facility Function:	
Implementation Phase:		Implementation Date:	
Official Responsible:

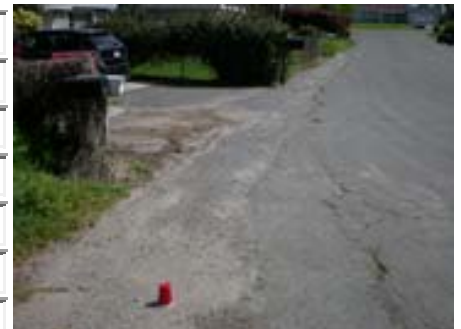
Field Date:	4/4/2011	Report Date:	4/4/2011	Barrier #:	6599
Location:	Mandarin Cir - North				
X Coordinate:	-121.25535				
Y Coordinate:	38.69899				
Barrier Area:	Sidewalks				
Barrier Type:	No sidewalk				
Code Ref:	CBC 1127B.1 and ADA/ABA 206.2.1

As Built Meas:	275	Quantity:	LF
Description:	No pedestrian route provided		
As Built Desc:	No sidewalk provided		
Solution:	Construct new firm and stable pedestrian route		
Bar. Severity:	1 Necessary	Cost Estimate:	\$27,500.00
		Status:	
Implementation Priority:	4	Facility Function:	
Implementation Phase:		Implementation Date:	
Official Responsible:

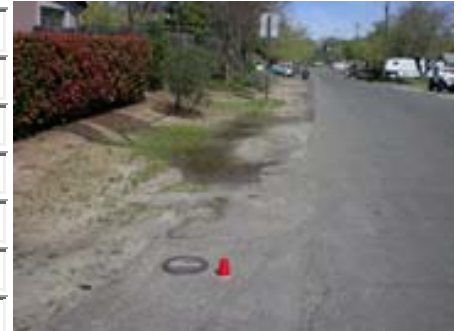
Field Date:	4/4/2011	Report Date:	4/4/2011	Barrier #:	6600
Location:	Melva St - West				
X Coordinate:	-121.25434				
Y Coordinate:	38.6991				
Barrier Area:	Sidewalks				
Barrier Type:	No sidewalk				
Code Ref:	CBC 1127B.1 and ADA/ABA 206.2.1

As Built Meas:	441	Quantity:	LF
Description:	No pedestrian route provided		
As Built Desc:	No sidewalk provided		
Solution:	Construct new firm and stable pedestrian route		
Bar. Severity:	1 Necessary	Cost Estimate:	\$44,100.00
Implementation Priority:	4	Facility Function:	
Implementation Phase:		Implementation Date:	
Official Responsible:

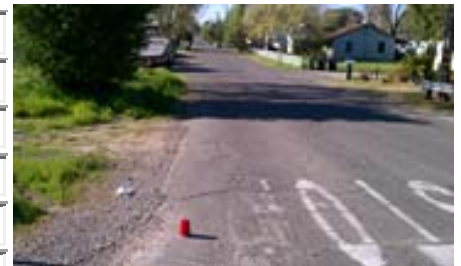
Field Date:	4/6/2011	Report Date:	4/6/2011	Barrier #:	6601
Location:	Cross Dr - East				
X Coordinate:	-121.25796				
Y Coordinate:	38.70036				
Barrier Area:	Sidewalks				
Barrier Type:	No sidewalk				
Code Ref:	CBC 1127B.1 and ADA/ABA 206.2.1

As Built Meas:	1397	Quantity:	LF
Description:	No pedestrian route provided		
As Built Desc:	No sidewalk provided		
Solution:	Construct new firm and stable pedestrian route		
Bar. Severity:	1 Necessary	Cost Estimate:	\$139,700.00
Implementation Priority:	4	Facility Function:	
Implementation Phase:		Implementation Date:	
Official Responsible:

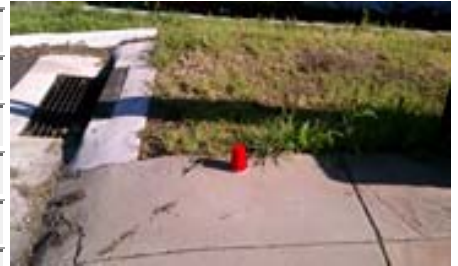
Field Date:	4/6/2011	Report Date:	4/6/2011	Barrier #:	6602
Location:	Cross Dr - East				
X Coordinate:	-121.258				
Y Coordinate:	38.69652				
Barrier Area:	Sidewalks				
Barrier Type:	No Sidewalk - No Barricade				
Code Ref:	MUTCD Section 6D.01

As Built Meas:	1	Quantity:	JOB
Description:	No barricade provided where sidewalk ends in hazardous location		
As Built Desc:	No barricade or other warning provided for the visually impaired at end of sidewalk		
Solution:	Provide barricade with cane detectable warning at end of sidewalk		
Bar. Severity:	1 Necessary	Cost Estimate:	\$1,350.00
Implementation Priority:	4	Facility Function:	
Implementation Phase:		Implementation Date:	
Official Responsible:

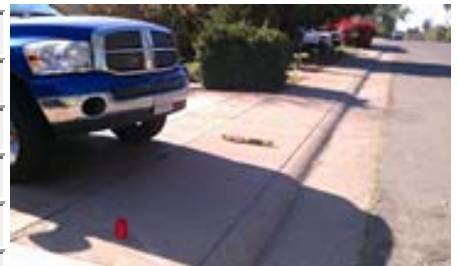
Field Date:	4/6/2011	Report Date:	4/6/2011	Barrier #:	6603
Location:	Cross Dr - East				
X Coordinate:	-121.25802				
Y Coordinate:	38.69648				
Barrier Area:	Sidewalks				
Barrier Type:	Cross Slope - Existing (2.1% to 3.0%)				
Code Ref:	CBC 1133B.7.1.3 and ADA/ABA 403.3

As Built Meas:	98	Quantity:	LF
Description:	Cross slope exceeds 2.0% (2.1% to 3.0%)		
As Built Desc:	3.0% cross slope		
Solution:	Low severity barrier - no remediation recommended		
Bar. Severity:	4 Low Severity	Cost Estimate:	\$0.00
Implementation Priority:	4	Facility Function:	
Implementation Phase:		Implementation Date:	
Official Responsible:

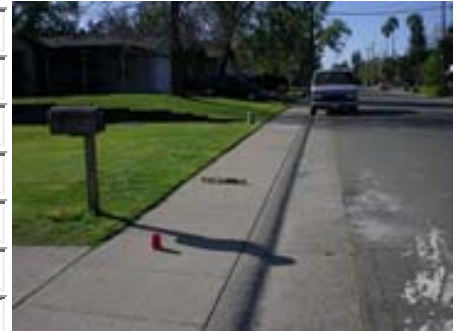
Field Date:	4/6/2011	Report Date:	4/6/2011	Barrier #:	6604A
Location:	Cross Dr - East				
X Coordinate:	-121.25797				
Y Coordinate:	38.69587				
Barrier Area:	Sidewalks				
Barrier Type:	Cross Slope - Existing (2.1% to 3.0%)				
Code Ref:	CBC 1133B.7.1.3 and ADA/ABA 403.3

As Built Meas:	117	Quantity:	LF
Description:	Cross slope exceeds 2.0% (2.1% to 3.0%)		
As Built Desc:	3.0% cross slope		
Solution:	Low severity barrier - no remediation recommended		
Bar. Severity:	4 Low Severity	Cost Estimate:	\$0.00
Implementation Priority:	4	Facility Function:	
Implementation Phase:		Implementation Date:	
Official Responsible:

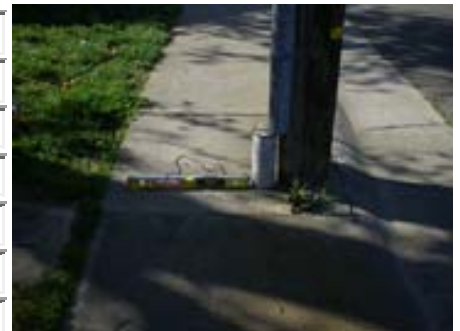
Field Date:	4/6/2011	Report Date:	4/6/2011	Barrier #:	6604B
Location:	Cross Dr - East				
X Coordinate:	-121.25797				
Y Coordinate:	38.69559				
Barrier Area:	Sidewalks				
Barrier Type:	Clear Width - Existing ($\leq 31"$ or less)				
Code Ref:	CBC 1133B.7.1

As Built Meas:	1	Quantity:	LF
Description:	Pedestrian route is not min. 48" wide ($\leq 31"$ or less)		
As Built Desc:	24" clear width due to foliage		
Solution:	Trim foliage to provide min. 48" clear width		
Bar. Severity:	1 Necessary	Cost Estimate:	\$125.00
Implementation Priority:	4	Facility Function:	
Implementation Phase:		Implementation Date:	
Official Responsible:

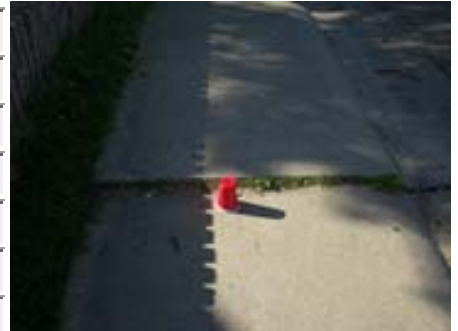
Field Date:	4/6/2011	Report Date:	4/6/2011	Barrier #:	6605
Location:	Cross Dr - East				
X Coordinate:	-121.25799				
Y Coordinate:	38.69534				
Barrier Area:	Sidewalks				
Barrier Type:	Abrupt Change in Level - > 1/2"				
Code Ref:	CBC 1133B.7.1 and ADA/ABA 303.3

As Built Meas:	4	Quantity:	LF
Description:	Change in level greater than 1/2"		
As Built Desc:	1/2" lip in sidewalk surface		
Solution:	Grind or repair sidewalk to remove trip hazard		
Bar. Severity:	1 Necessary	Cost Estimate:	\$1,000.00
Implementation Priority:	4	Facility Function:	
Implementation Phase:		Implementation Date:	
Official Responsible:			
Notes:

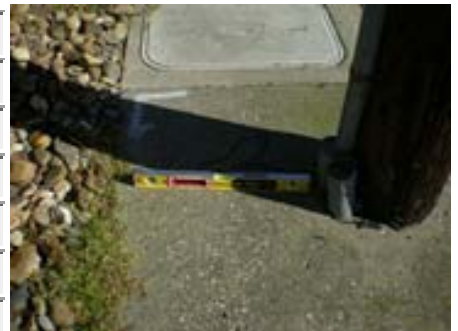
Field Date:	4/6/2011	Report Date:	4/6/2011	Barrier #:	6606
Location:	Cross Dr - West				
X Coordinate:	-121.25812				
Y Coordinate:	38.69317				
Barrier Area:	Sidewalks				
Barrier Type:	Clear Width - Existing ($\leq 31"$ or less)				
Code Ref:	CBC 1133B.7.1

As Built Meas:	1	Quantity:	LF
Description:	Pedestrian route is not min. 48" wide ($\leq 31"$ or less)		
As Built Desc:	24" clear width due to foliage		
Solution:	Trim foliage to provide min. 48" clear width		
Bar. Severity:	1 Necessary	Cost Estimate:	\$125.00
Implementation Priority:	4	Facility Function:	
Implementation Phase:		Implementation Date:	
Official Responsible:			
Notes:

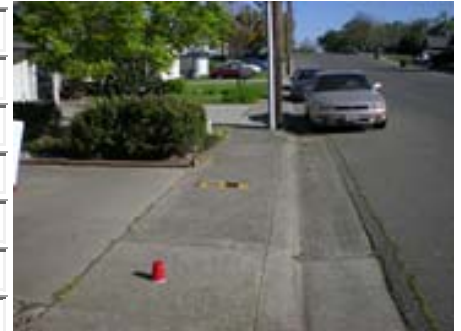
Barrier Type: Cross Slope - Existing (3.1% to 4.0%)

Code Ref: CBC 1133B.7.1.3 and ADA/ABA 403.3

As Built Meas: 44 Quantity: LF

Description: Cross slope exceeds 2.0% (3.1% to 4.0%)

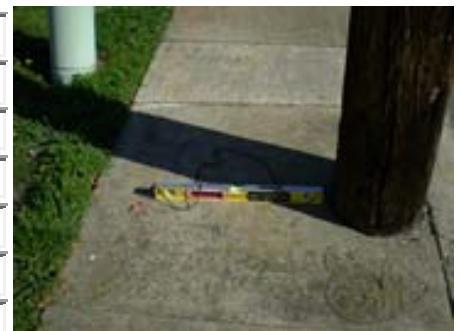
Barrier Type: Clear Width - Existing ($\leq 31"$ or less)

Code Ref: CBC 1133B.7.1

As Built Meas: 2 Quantity: LF

Description: Pedestrian route is not min. 48" wide ($\leq 31"$ or less)

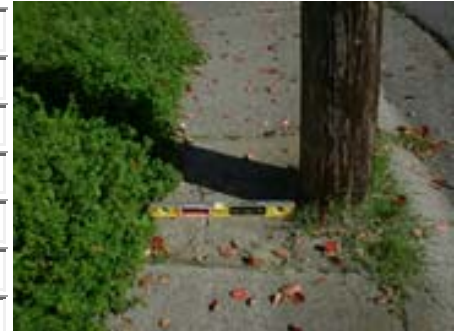
Field Date:	4/6/2011	Report Date:	4/6/2011	Barrier #:	6609
Location:	Cross Dr - West				
X Coordinate:	-121.25812				
Y Coordinate:	38.69407				
Barrier Area:	Sidewalks				
Barrier Type:	Clear Width - Existing ($\leq 31"$ or less)				
Code Ref:	CBC 1133B.7.1

As Built Meas:	2	Quantity:	LF
Description:	Pedestrian route is not min. 48" wide ($\leq 31"$ or less)		
As Built Desc:	24" clear width due to pole		
Solution:	Demolish existing and construct new route		
Bar. Severity:	1 Necessary	Cost Estimate:	\$250.00
Implementation Priority:	4	Facility Function:	
Implementation Phase:		Implementation Date:	
Official Responsible:			
Notes:

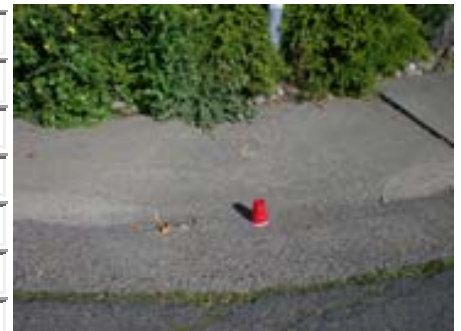
Field Date:	4/6/2011	Report Date:	4/6/2011	Barrier #:	6610
Location:	Cross Dr and Stacey Hills Dr - Corner A				
X Coordinate:	-121.25817				
Y Coordinate:	38.69425				
Barrier Area:	Curb Ramps				
Barrier Type:	No Curb Ramp - Depressed Existing Curb				
Code Ref:	CBC 1127B.5.1 and ADA/ABA 402.2

As Built Meas:	1	Quantity:	EACH
Description:	No compliant curb cut at corner (intersection)		
As Built Desc:	10.4% running slope at depressed area		
Solution:	Demolish existing and construct curb cut		
Bar. Severity:	1 Necessary	Cost Estimate:	\$2,500.00
Implementation Priority:	4	Facility Function:	
Implementation Phase:		Implementation Date:	
Official Responsible:			
Notes:	Two - way intersection corners A,D

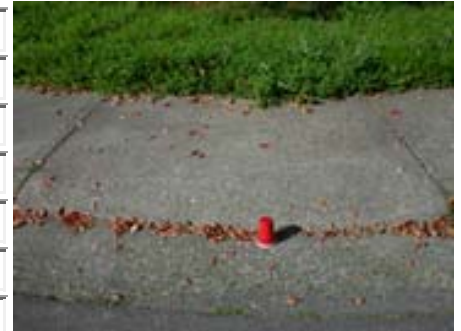
Field Date:	4/6/2011	Report Date:	4/6/2011	Barrier #:	6611
Location:	Cross Dr and Stacey Hills Dr - Corner D				
X Coordinate:	-121.25815				
Y Coordinate:	38.69412				
Barrier Area:	Curb Ramps				
Barrier Type:	No Curb Ramp - Depressed Existing Curb				
Code Ref:	CBC 1127B.5.1 and ADA/ABA 402.2

As Built Meas:	1	Quantity:	EACH
Description:	No compliant curb cut at corner (intersection)		
As Built Desc:	13.1% running slope at depressed area		
Solution:	Demolish existing and construct curb cut		
Bar. Severity:	1 Necessary	Cost Estimate:	\$2,500.00
Implementation Priority:	4	Facility Function:	
Implementation Phase:		Implementation Date:	
Official Responsible:			
Notes:	Two - way intersection corners A,D

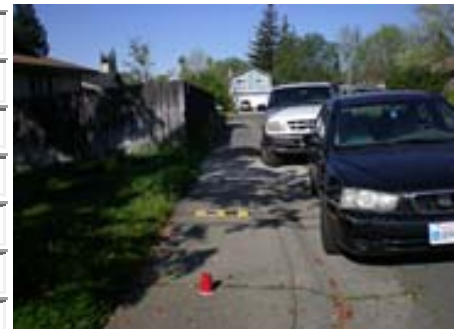
Field Date:	4/6/2011	Report Date:	4/6/2011	Barrier #:	6612A
Location:	Stacey Hills Dr - South				
X Coordinate:	-121.25824				
Y Coordinate:	38.6941				
Barrier Area:	Sidewalks				
Barrier Type:	Cross Slope - Existing (3.1% to 4.0%)				
Code Ref:	CBC 1133B.7.1.3 and ADA/ABA 403.3

As Built Meas:	216	Quantity:	LF
Description:	Cross slope exceeds 2.0% (3.1% to 4.0%)		
As Built Desc:	3.3% cross slope		
Solution:	Demolish existing and construct new route		
Bar. Severity:	3 Hindrance	Cost Estimate:	\$27,000.00
Implementation Priority:	4	Facility Function:	
Implementation Phase:		Implementation Date:	
Official Responsible:			
Notes:

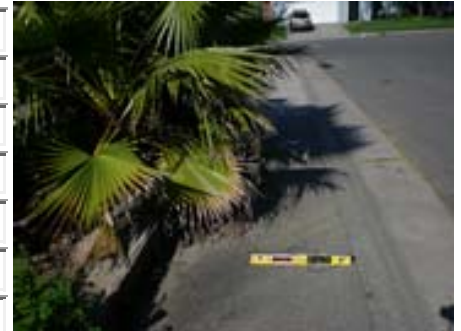
Field Date:	4/6/2011	Report Date:	4/6/2011	Barrier #:	6612B
Location:	Stacey Hills Dr - South				
X Coordinate:	-121.25863				
Y Coordinate:	38.6941				
Barrier Area:	Sidewalks				
Barrier Type:	Clear Width - Existing ($\leq 31"$ or less)				
Code Ref:	CBC 1133B.7.1

As Built Meas:	1	Quantity:	LF
Description:	Pedestrian route is not min. 48" wide ($\leq 31"$ or less)		
As Built Desc:	24" clear width due to foliage		
Solution:	Trim foliage to provide min. 48" clear width		
Bar. Severity:	1 Necessary	Cost Estimate:	\$125.00
Implementation Priority:	4	Facility Function:	
Implementation Phase:		Implementation Date:	
Official Responsible:

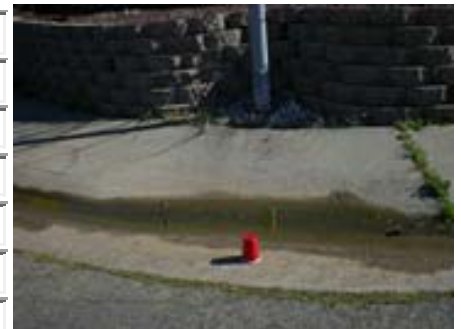
Field Date:	4/6/2011	Report Date:	4/6/2011	Barrier #:	6613
Location:	Stacey Hills Dr and Stacey Hills Dr - Corner B				
X Coordinate:	-121.25894				
Y Coordinate:	38.69422				
Barrier Area:	Curb Ramps				
Barrier Type:	No Curb Ramp - Depressed Existing Curb				
Code Ref:	CBC 1127B.5.1 and ADA/ABA 402.2

As Built Meas:	1	Quantity:	EACH
Description:	No compliant curb cut at corner (intersection)		
As Built Desc:	9.0% running slope at depressed area		
Solution:	Demolish existing and construct curb cut		
Bar. Severity:	1 Necessary	Cost Estimate:	\$2,500.00
Implementation Priority:	4	Facility Function:	
Implementation Phase:		Implementation Date:	
Official Responsible:

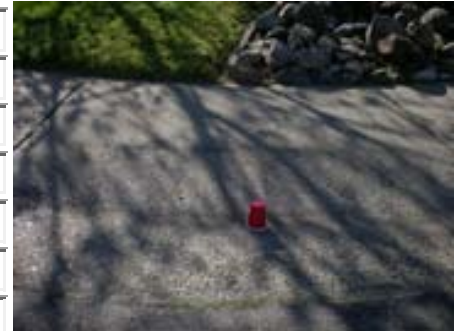
Barrier Type: No Curb Ramp - Depressed Existing Curb

Code Ref: CBC 1127B.5.1 and ADA/ABA 402.2

As Built Meas: 1 Quantity: EACH

Description: No compliant curb cut at corner (intersection)

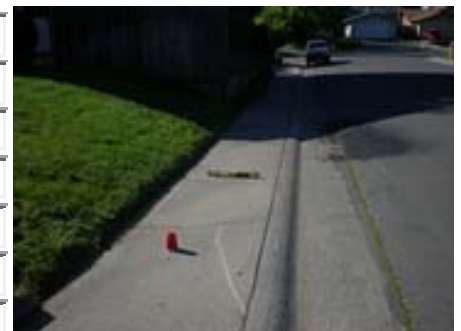
Barrier Type: Cross Slope - Existing (3.1% to 4.0%)

Code Ref: CBC 1133B.7.1.3 and ADA/ABA 403.3

As Built Meas: 211 Quantity: LF

Description: Cross slope exceeds 2.0% (3.1% to 4.0%)

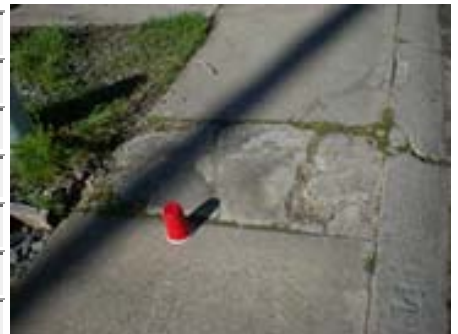
Barrier Type: Surface Condition - Damaged

Code Ref: CBC 1133B.7.1 and ADA/ABA 302.1

As Built Meas: 4 Quantity: LF

Description: Surface is not firm and stable (cracked, broken or loose soil, etc.)

As Built Desc: Cracked concrete

Solution: Repair surface to make firm and stable

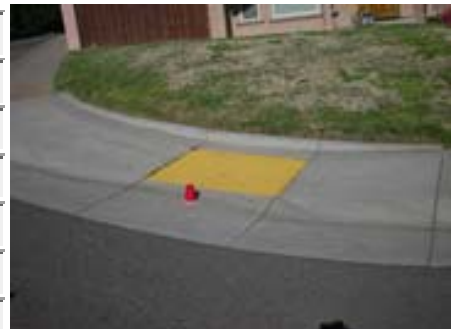
Barrier Type: 12" Grooves - Existing (4.1% to 4.9%)

Code Ref: CBC 1127B.5.6

As Built Meas: 1 Quantity: EACH

Description: 12" grooves at top of curb ramp are not level (4.1% to 4.9%)

Bar. Severity: 2 Recommended Cost Estimate: \$2,500.00 Status:

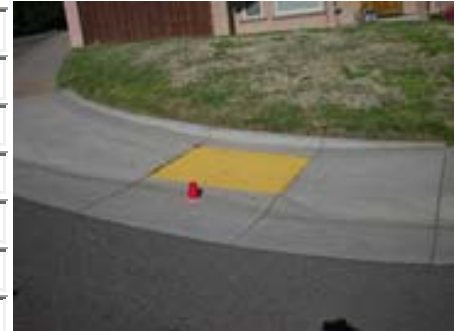
Field Date:	4/6/2011	Report Date:	4/6/2011	Barrier #:	6617B
Location:	Stacey Hills Dr and Checkerbloom Wy - Corner A				
X Coordinate:	-121.26184				
Y Coordinate:	38.69365				
Barrier Area:	Curb Ramps				
Barrier Type:	Cross Slope - Existing (5.0% or more)				
Code Ref:	CBC 1127B.5.3 and ADA/ABA 406.2

As Built Meas:	1	Quantity:	EACH
Description:	Ramp run cross slope exceeds 2.0% (5.0% or more)		
As Built Desc:	9.3% cross slope		
Solution:	Demolish existing and construct new curb ramp		
Bar. Severity:	1 Necessary	Cost Estimate:	\$0.00
Implementation Priority:	4	Facility Function:	
Implementation Phase:		Implementation Date:	
Official Responsible:			
Notes:	Two - way intersection corners A,B

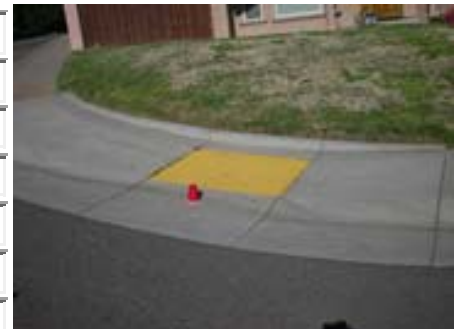
Field Date:	4/6/2011	Report Date:	4/6/2011	Barrier #:	6617C
Location:	Stacey Hills Dr and Checkerbloom Wy - Corner A				
X Coordinate:	-121.26184				
Y Coordinate:	38.69365				
Barrier Area:	Curb Ramps				
Barrier Type:	Parallel Ramp Landing - Existing (>5.0% or more)				
Code Ref:	CBC 1127B.5.4 and ADA/ABA 406.4

As Built Meas:	1	Quantity:	EACH
Description:	Curb ramp landing or pan not level (>5.0% or more)		
As Built Desc:	9.1% landing slope		
Solution:	Demolish existing and construct new transition		
Bar. Severity:	1 Necessary	Cost Estimate:	\$0.00
Implementation Priority:	4	Facility Function:	
Implementation Phase:		Implementation Date:	
Official Responsible:			
Notes:	Two - way intersection corners A,B

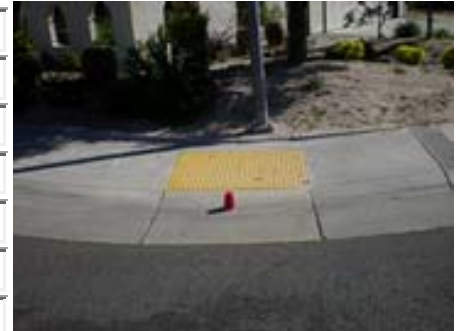
Field Date:	4/6/2011	Report Date:	4/6/2011	Barrier #:	6618A
Location:	Stacey Hills Dr and Checkerbloom Wy - Corner B				
X Coordinate:	-121.26168				
Y Coordinate:	38.6936				
Barrier Area:	Curb Ramps				
Barrier Type:	12" Grooves - Existing (>5.0%)				
Code Ref:	CBC 1127B.5.6

As Built Meas:	1	Quantity:	EACH
Description:	12" grooves at top of curb ramp are not level (>5.0%)		
As Built Desc:	6.4% at 12" grooves		
Solution:	Demolish existing and construct new curb ramp		
Bar. Severity:	1 Necessary	Cost Estimate:	\$2,500.00
Implementation Priority:	4	Facility Function:	
Implementation Phase:		Implementation Date:	
Official Responsible:			
Notes:	Two - way intersection corners A,B

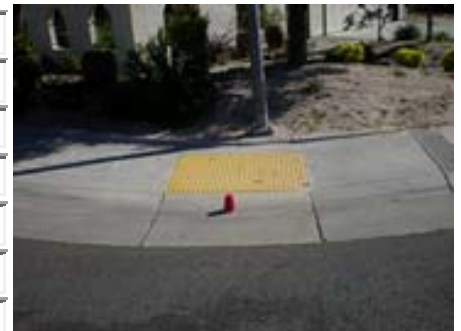
Field Date:	4/6/2011	Report Date:	4/6/2011	Barrier #:	6618B
Location:	Stacey Hills Dr and Checkerbloom Wy - Corner B				
X Coordinate:	-121.2619				
Y Coordinate:	38.69618				
Barrier Area:	Curb Ramps				
Barrier Type:	Parallel Ramp Landing - Existing (3.1% to 4.0%)				
Code Ref:	CBC 1127B.5.4 and ADA/ABA 406.4

As Built Meas:	1	Quantity:	EACH
Description:	Curb ramp landing or pan not level (3.1% to 4.0%)		
As Built Desc:	3.5% landing slope		
Solution:	Demolish existing and construct new transition		
Bar. Severity:	3 Hindrance	Cost Estimate:	\$0.00
Implementation Priority:	4	Facility Function:	
Implementation Phase:		Implementation Date:	
Official Responsible:			
Notes:	Two - way intersection corners A,B

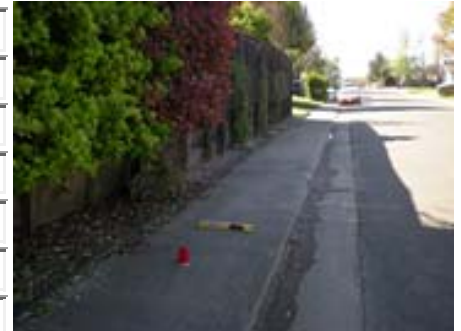
Field Date:	4/6/2011	Report Date:	4/6/2011	Barrier #:	6619
Location:	Checkerbloom Wy - East				
X Coordinate:	-121.26191				
Y Coordinate:	38.69621				
Barrier Area:	Sidewalks				
Barrier Type:	Cross Slope - Existing (3.1% to 4.0%)				
Code Ref:	CBC 1133B.7.1.3 and ADA/ABA 403.3

As Built Meas:	400	Quantity:	LF
Description:	Cross slope exceeds 2.0% (3.1% to 4.0%)		
As Built Desc:	4.0% cross slope		
Solution:	Demolish existing and construct new route		
Bar. Severity:	3 Hindrance	Cost Estimate:	\$50,000.00
Implementation Priority:	4	Facility Function:	
Implementation Phase:		Implementation Date:	
Official Responsible:

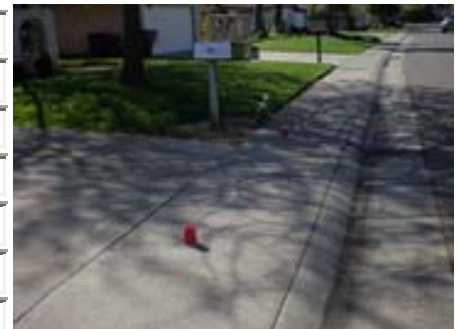
Field Date:	4/6/2011	Report Date:	4/6/2011	Barrier #:	6620
Location:	Checkerbloom Wy - East				
X Coordinate:	-121.26171				
Y Coordinate:	38.69435				
Barrier Area:	Sidewalks				
Barrier Type:	Surface Condition - Damaged				
Code Ref:	CBC 1133B.7.1 and ADA/ABA 302.1

As Built Meas:	8	Quantity:	LF
Description:	Surface is not firm and stable (cracked, broken or loose soil, etc.)		
As Built Desc:	Cracked concrete		
Solution:	Repair surface to make firm and stable		
Bar. Severity:	1 Necessary	Cost Estimate:	\$1,000.00
Implementation Priority:	4	Facility Function:	
Implementation Phase:		Implementation Date:	
Official Responsible:

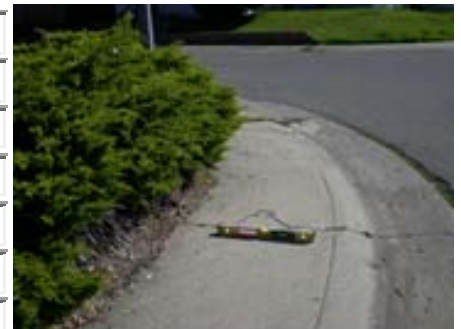
Field Date:	4/6/2011	Report Date:	4/6/2011	Barrier #:	6622
Location:	Stacey Hills Dr - North				
X Coordinate:	-121.26098				
Y Coordinate:	38.69361				
Barrier Area:	Sidewalks				
Barrier Type:	Clear Width - Existing ($\leq 31"$ or less)				
Code Ref:	CBC 1133B.7.1

As Built Meas:	1	Quantity:	LF
Description:	Pedestrian route is not min. 48" wide ($\leq 31"$ or less)		
As Built Desc:	24" clear width due to foliage		
Solution:	Trim foliage to provide min. 48" clear width		
Bar. Severity:	1 Necessary	Cost Estimate:	\$125.00
Implementation Priority:	4	Facility Function:	
Implementation Phase:		Implementation Date:	
Official Responsible:			
Notes:

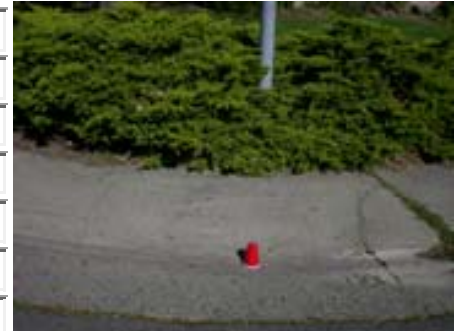
Field Date:	4/6/2011	Report Date:	4/6/2011	Barrier #:	6623
Location:	Stacey Hills Dr and Forbs Wy - Corner A				
X Coordinate:	-121.26094				
Y Coordinate:	38.69361				
Barrier Area:	Curb Ramps				
Barrier Type:	No Curb Ramp - Depressed Existing Curb				
Code Ref:	CBC 1127B.5.1 and ADA/ABA 402.2

As Built Meas:	1	Quantity:	EACH
Description:	No compliant curb cut at corner (intersection)		
As Built Desc:	9.6% running slope at depressed area		
Solution:	Demolish existing and construct curb cut		
Bar. Severity:	1 Necessary	Cost Estimate:	\$2,500.00
Implementation Priority:	4	Facility Function:	
Implementation Phase:		Implementation Date:	
Official Responsible:			
Notes:	Two - way intersection corners A,B

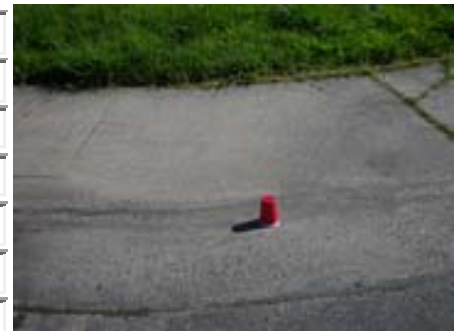
Field Date:	4/6/2011	Report Date:	4/6/2011	Barrier #:	6624
Location:	Stacey Hills Dr and Forbs Wy - Corner B				
X Coordinate:	-121.26078				
Y Coordinate:	38.69361				
Barrier Area:	Curb Ramps				
Barrier Type:	No Curb Ramp - Depressed Existing Curb				
Code Ref:	CBC 1127B.5.1 and ADA/ABA 402.2

As Built Meas:	1	Quantity:	EACH
Description:	No compliant curb cut at corner (intersection)		
As Built Desc:	7.0% running slope at depressed area		
Solution:	Demolish existing and construct curb cut		
Bar. Severity:	1 Necessary	Cost Estimate:	\$2,500.00
Implementation Priority:	4	Facility Function:	
Implementation Phase:		Implementation Date:	
Official Responsible:			
Notes:	Two - way intersection corners A,B

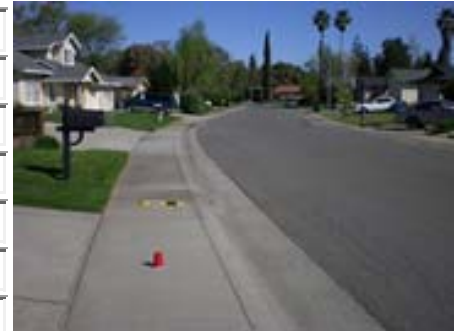
Field Date:	4/6/2011	Report Date:	4/6/2011	Barrier #:	6625
Location:	Forbs Wy - West				
X Coordinate:	-121.26105				
Y Coordinate:	38.69524				
Barrier Area:	Sidewalks				
Barrier Type:	Cross Slope - Existing (5.0% or more)				
Code Ref:	CBC 1133B.7.1.3 and ADA/ABA 403.3

As Built Meas:	347	Quantity:	LF
Description:	Cross slope exceeds 2.0% (5.0% or more)		
As Built Desc:	3.7% cross slope		
Solution:	Demolish existing and construct new route		
Bar. Severity:	1 Necessary	Cost Estimate:	\$43,375.00
Implementation Priority:	4	Facility Function:	
Implementation Phase:		Implementation Date:	
Official Responsible:			
Notes:

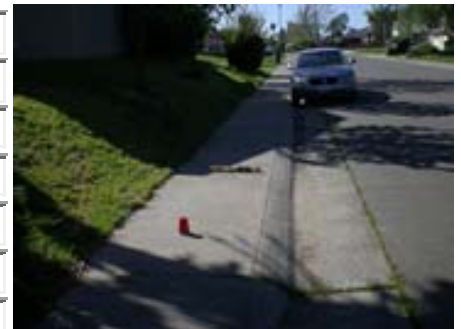
Field Date:	4/6/2011	Report Date:	4/6/2011	Barrier #:	6626A
Location:	Forbs Wy - East				
X Coordinate:	-121.26097				
Y Coordinate:	38.69614				
Barrier Area:	Sidewalks				
Barrier Type:	Cross Slope - Existing (3.1% to 4.0%)				
Code Ref:	CBC 1133B.7.1.3 and ADA/ABA 403.3

As Built Meas:	933	Quantity:	LF
Description:	Cross slope exceeds 2.0% (3.1% to 4.0%)		
As Built Desc:	3.6% cross slope		
Solution:	Demolish existing and construct new route		
Bar. Severity:	3 Hindrance	Cost Estimate:	\$116,625.00
Implementation Priority:	4	Facility Function:	
Implementation Phase:		Implementation Date:	
Official Responsible:			
Notes:

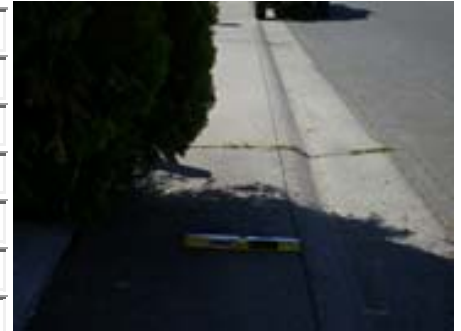
Field Date:	4/6/2011	Report Date:	4/6/2011	Barrier #:	6626B
Location:	Forbs Wy - East				
X Coordinate:	-121.26079				
Y Coordinate:	38.69484				
Barrier Area:	Sidewalks				
Barrier Type:	Clear Width - Existing ($\leq 31"$ or less)				
Code Ref:	CBC 1133B.7.1

As Built Meas:	1	Quantity:	LF
Description:	Pedestrian route is not min. 48" wide ($\leq 31"$ or less)		
As Built Desc:	24" clear width due to foliage		
Solution:	Trim foliage to provide min. 48" clear width		
Bar. Severity:	1 Necessary	Cost Estimate:	\$125.00
Implementation Priority:	4	Facility Function:	
Implementation Phase:		Implementation Date:	
Official Responsible:			
Notes:

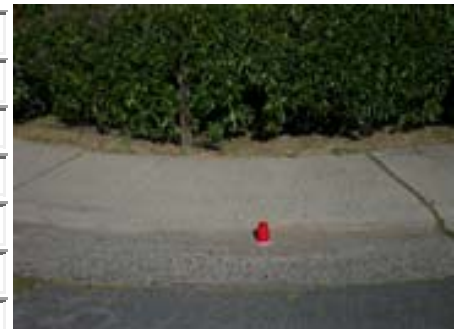
Field Date:	4/6/2011	Report Date:	4/6/2011	Barrier #:	6627
Location:	Stacey Hills Dr and Yarrow Wy - Corner A				
X Coordinate:	-121.26002				
Y Coordinate:	38.69364				
Barrier Area:	Curb Ramps				
Barrier Type:	No Curb Ramp - Depressed Existing Curb				
Code Ref:	CBC 1127B.5.1 and ADA/ABA 402.2

As Built Meas:	1	Quantity:	EACH
Description:	No compliant curb cut at corner (intersection)		
As Built Desc:	9.1% running slope at depressed area		
Solution:	Demolish existing and construct curb cut		
Bar. Severity:	1 Necessary	Cost Estimate:	\$2,500.00
Implementation Priority:	4	Facility Function:	
Implementation Phase:		Implementation Date:	
Official Responsible:			
Notes:	Two - way intersection corners A,B

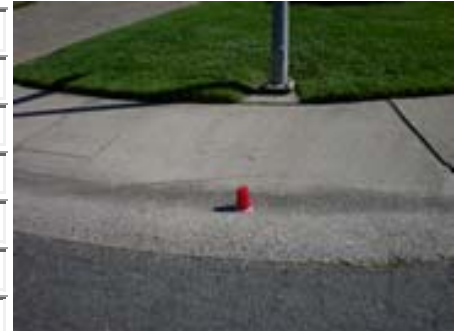
Field Date:	4/6/2011	Report Date:	4/6/2011	Barrier #:	6628
Location:	Stacey Hills Dr and Yarrow Wy - Corner B				
X Coordinate:	-121.25988				
Y Coordinate:	38.69364				
Barrier Area:	Curb Ramps				
Barrier Type:	No Curb Ramp - Depressed Existing Curb				
Code Ref:	CBC 1127B.5.1 and ADA/ABA 402.2

As Built Meas:	1	Quantity:	EACH
Description:	No compliant curb cut at corner (intersection)		
As Built Desc:	9.2% running slope at depressed area		
Solution:	Demolish existing and construct curb cut		
Bar. Severity:	1 Necessary	Cost Estimate:	\$2,500.00
Implementation Priority:	4	Facility Function:	
Implementation Phase:		Implementation Date:	
Official Responsible:			
Notes:	Two - way intersection corners A,B

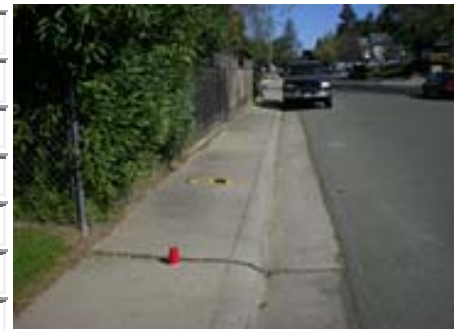
Field Date:	4/6/2011	Report Date:	4/6/2011	Barrier #:	6629A
Location:	Yarrow Wy - West				
X Coordinate:	-121.26001				
Y Coordinate:	38.6937				
Barrier Area:	Sidewalks				
Barrier Type:	Cross Slope - Existing (3.1% to 4.0%)				
Code Ref:	CBC 1133B.7.1.3 and ADA/ABA 403.3

As Built Meas:	918	Quantity:	LF
Description:	Cross slope exceeds 2.0% (3.1% to 4.0%)		
As Built Desc:	4.0% cross slope		
Solution:	Demolish existing and construct new route		
Bar. Severity:	3 Hindrance	Cost Estimate:	\$114,750.00
Implementation Priority:	4	Facility Function:	
Implementation Phase:		Implementation Date:	
Official Responsible:			
Notes:

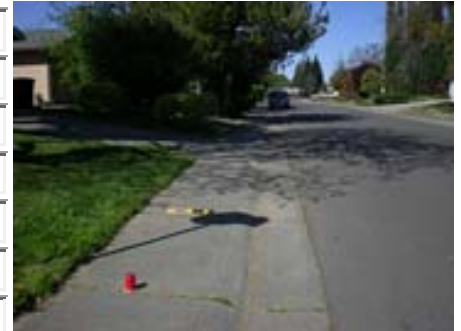
Barrier Type: Cross Slope - Existing (3.1% to 4.0%)

Code Ref: CBC 1133B.7.1.3 and ADA/ABA 403.3

As Built Meas: 178 Quantity: LF

Description: Cross slope exceeds 2.0% (3.1% to 4.0%)

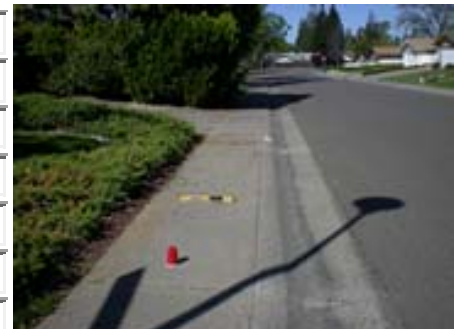
Barrier Type: Cross Slope - Existing (3.1% to 4.0%)

Code Ref: CBC 1133B.7.1.3 and ADA/ABA 403.3

As Built Meas: 200 Quantity: LF

Description: Cross slope exceeds 2.0% (3.1% to 4.0%)

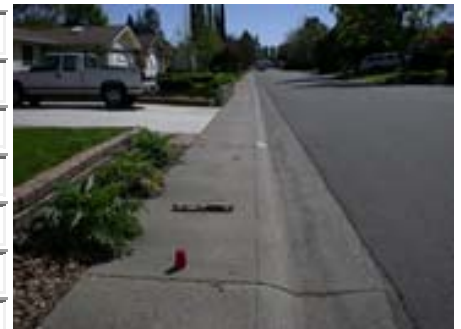
Field Date:	4/6/2011	Report Date:	4/6/2011	Barrier #:	6633A
Location:	Poppyfield Wy - North				
X Coordinate:	-121.26228				
Y Coordinate:	38.69633				
Barrier Area:	Sidewalks				
Barrier Type:	Cross Slope - Existing (4.1% to 4.9%)				
Code Ref:	CBC 1133B.7.1.3 and ADA/ABA 403.3

As Built Meas:	583	Quantity:	LF
Description:	Cross slope exceeds 2.0% (4.1% to 4.9%)		
As Built Desc:	4.1% cross slope		
Solution:	Demolish existing and construct new route		
Bar. Severity:	2 Recommended	Cost Estimate:	\$72,875.00
Implementation Priority:	4	Facility Function:	
Implementation Phase:		Implementation Date:	
Official Responsible:			
Notes:

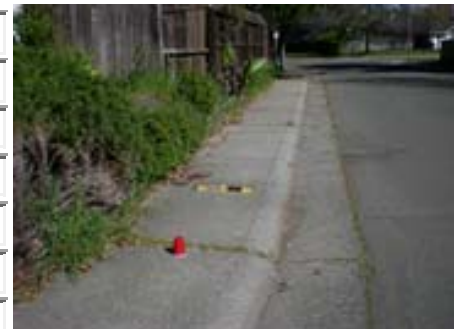
Field Date:	4/6/2011	Report Date:	4/6/2011	Barrier #:	6634A
Location:	Yarrow Wy - West				
X Coordinate:	-121.26023				
Y Coordinate:	38.69638				
Barrier Area:	Sidewalks				
Barrier Type:	Cross Slope - Existing (4.1% to 4.9%)				
Code Ref:	CBC 1133B.7.1.3 and ADA/ABA 403.3

As Built Meas:	417	Quantity:	LF
Description:	Cross slope exceeds 2.0% (4.1% to 4.9%)		
As Built Desc:	4.3% cross slope		
Solution:	Demolish existing and construct new route		
Bar. Severity:	2 Recommended	Cost Estimate:	\$52,125.00
Implementation Priority:	4	Facility Function:	
Implementation Phase:		Implementation Date:	
Official Responsible:			
Notes:

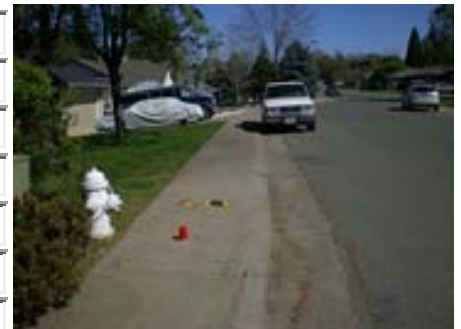
Field Date:	4/6/2011	Report Date:	4/6/2011	Barrier #:	6635
Location:	Yarrow Wy - West				
X Coordinate:	-121.26092				
Y Coordinate:	38.69737				
Barrier Area:	Sidewalks				
Barrier Type:	Cross Slope - Existing (4.1% to 4.9%)				
Code Ref:	CBC 1133B.7.1.3 and ADA/ABA 403.3

As Built Meas:	750	Quantity:	LF
Description:	Cross slope exceeds 2.0% (4.1% to 4.9%)		
As Built Desc:	4.4% cross slope		
Solution:	Demolish existing and construct new route		
Bar. Severity:	2 Recommended	Cost Estimate:	\$93,750.00
Implementation Priority:	4	Facility Function:	
Implementation Phase:		Implementation Date:	
Official Responsible:			
Notes:

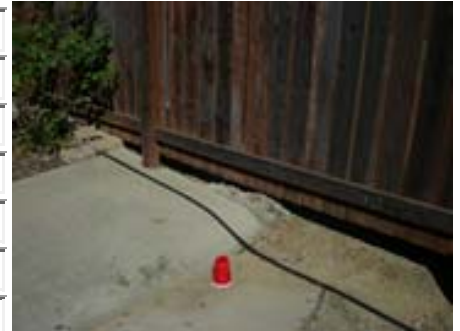
Field Date:	4/6/2011	Report Date:	4/6/2011	Barrier #:	6636
Location:	Yarrow Wy - West				
X Coordinate:	-121.26078				
Y Coordinate:	38.69939				
Barrier Area:	Sidewalks				
Barrier Type:	No Sidewalk - Transition to Shoulder				
Code Ref:	CBC 1121B.2 and ADA/ABA 206.2.1

As Built Meas:	1	Quantity:	JOB
Description:	Sidewalk ends and no ramp to pedestrian shoulder is provided		
As Built Desc:	No ramp to shoulder to enable pedestrian travel onto existing shoulder		
Solution:	Provide transition ramp to paved shoulder where no opposite sidewalk exists		
Bar. Severity:	1 Necessary	Cost Estimate:	\$2,500.00
Implementation Priority:	4	Facility Function:	
Implementation Phase:		Implementation Date:	
Official Responsible:

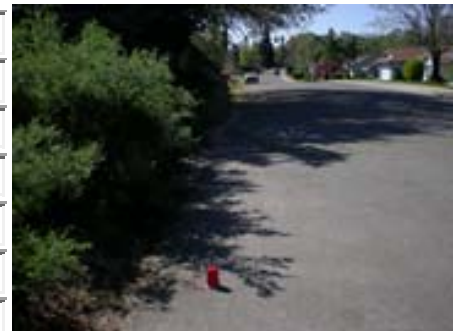
Field Date:	4/6/2011	Report Date:	4/6/2011	Barrier #:	6637
Location:	Yarrow Wy - East				
X Coordinate:	-121.26072				
Y Coordinate:	38.69935				
Barrier Area:	Sidewalks				
Barrier Type:	No sidewalk				
Code Ref:	CBC 1127B.1 and ADA/ABA 206.2.1

As Built Meas:	148	Quantity:	LF
Description:	No pedestrian route provided		
As Built Desc:	No sidewalk provided		
Solution:	Construct new firm and stable pedestrian route		
Bar. Severity:	1 Necessary	Cost Estimate:	\$14,800.00
Implementation Priority:	4	Facility Function:	
Implementation Phase:		Implementation Date:	
Official Responsible:

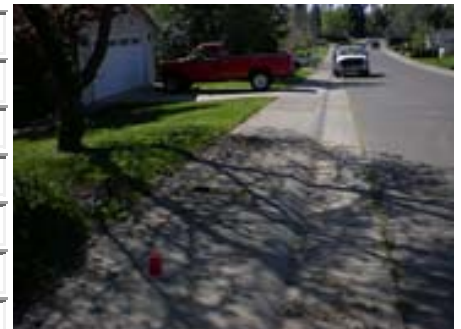
Field Date:	4/6/2011	Report Date:	4/6/2011	Barrier #:	6639A
Location:	Yarrow Wy - East				
X Coordinate:	-121.26069				
Y Coordinate:	38.69893				
Barrier Area:	Sidewalks				
Barrier Type:	Cross Slope - Existing (5.0% or more)				
Code Ref:	CBC 1133B.7.1.3 and ADA/ABA 403.3

As Built Meas:	629	Quantity:	LF
Description:	Cross slope exceeds 2.0% (5.0% or more)		
As Built Desc:	5.8% cross slope		
Solution:	Demolish existing and construct new route		
Bar. Severity:	1 Necessary	Cost Estimate:	\$78,625.00
Implementation Priority:	4	Facility Function:	
Implementation Phase:		Implementation Date:	
Official Responsible:			
Notes:

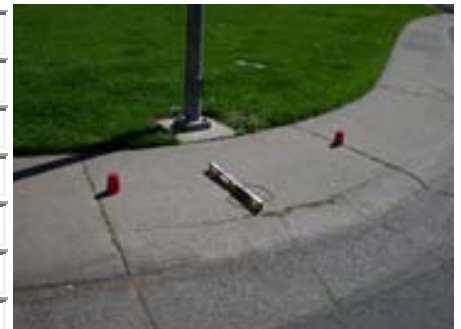
Field Date:	4/6/2011	Report Date:	4/6/2011	Barrier #:	6640
Location:	Yarrow Wy - East				
X Coordinate:	-121.26073				
Y Coordinate:	38.6972				
Barrier Area:	Sidewalks				
Barrier Type:	Elbow in Sidewalk - Cross Slope (5.0% or more)				
Code Ref:	CBC 1133B.7.1.3 and ADA/ABA 403.3

As Built Meas:	6	Quantity:	LF
Description:	Cross slope at elbow exceeds 2.0% (5.0% or more)		
As Built Desc:	10.3% cross slope		
Solution:	Demolish existing and construct new sidewalk without curb ramp		
Bar. Severity:	1 Necessary	Cost Estimate:	\$750.00
Implementation Priority:	4	Facility Function:	
Implementation Phase:		Implementation Date:	
Official Responsible:

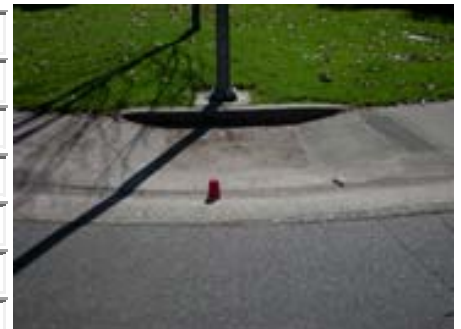
Field Date:	4/6/2011	Report Date:	4/6/2011	Barrier #:	6642
Location:	Yarrow Wy and Juli Ct - Corner C				
X Coordinate:	-121.26013				
Y Coordinate:	38.6968				
Barrier Area:	Curb Ramps				
Barrier Type:	Detectable Warnings - Truncated Domes				
Code Ref:	CBC 1127B.5.7 and ADA/ABA 705.1.3

As Built Meas:	1	Quantity:	EACH
Description:	No truncated domes provided at curb ramp		
As Built Desc:	No detectable warnings at curb ramp		
Solution:	Provide compliant truncated domes		
Bar. Severity:	2 Recommended	Cost Estimate:	\$1,400.00
Implementation Priority:	4	Facility Function:	
Implementation Phase:		Implementation Date:	
Official Responsible:

Notes: Two - way intersection corners B,C

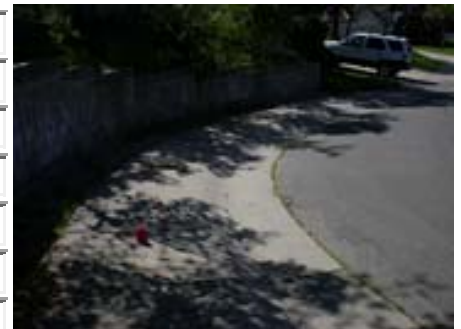
Field Date:	4/6/2011	Report Date:	4/6/2011	Barrier #:	6644
Location:	Juli Ct - South				
X Coordinate:	-121.25949				
Y Coordinate:	38.69753				
Barrier Area:	Sidewalks				
Barrier Type:	Cross Slope - Existing (4.1% to 4.9%)				
Code Ref:	CBC 1133B.7.1.3 and ADA/ABA 403.3

As Built Meas:	345	Quantity:	LF
Description:	Cross slope exceeds 2.0% (4.1% to 4.9%)		
As Built Desc:	4.4% cross slope		
Solution:	Demolish existing and construct new route		
Bar. Severity:	2 Recommended	Cost Estimate:	\$43,125.00
Implementation Priority:	4	Facility Function:	
Implementation Phase:		Implementation Date:	
Official Responsible:

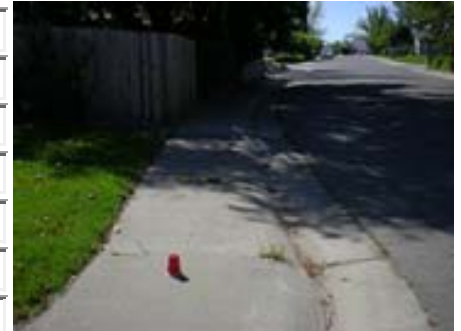
Field Date:	4/6/2011	Report Date:	4/6/2011	Barrier #:	6645A
Location:	Yarrow Wy - East				
X Coordinate:	-121.26014				
Y Coordinate:	38.69677				
Barrier Area:	Sidewalks				
Barrier Type:	Cross Slope - Existing (3.1% to 4.0%)				
Code Ref:	CBC 1133B.7.1.3 and ADA/ABA 403.3

As Built Meas:	145	Quantity:	LF
Description:	Cross slope exceeds 2.0% (3.1% to 4.0%)		
As Built Desc:	3.7% cross slope		
Solution:	Demolish existing and construct new route		
Bar. Severity:	3 Hindrance	Cost Estimate:	\$18,125.00
Implementation Priority:	4	Facility Function:	
Implementation Phase:		Implementation Date:	
Official Responsible:			
Notes:

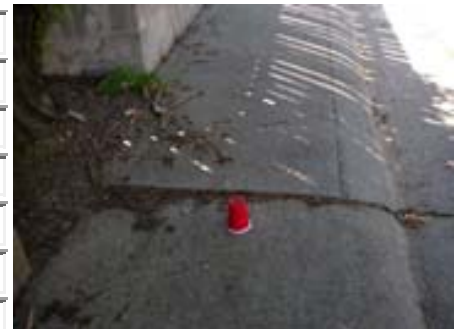
Field Date:	4/6/2011	Report Date:	4/6/2011	Barrier #:	6645B
Location:	Yarrow Wy - East				
X Coordinate:	-121.26014				
Y Coordinate:	38.69664				
Barrier Area:	Sidewalks				
Barrier Type:	Abrupt Change in Level - > 1/2"				
Code Ref:	CBC 1133B.7.1 and ADA/ABA 303.3

As Built Meas:	4	Quantity:	LF
Description:	Change in level greater than 1/2"		
As Built Desc:	1/2" lip in sidewalk surface		
Solution:	Grind or repair sidewalk to remove trip hazard		
Bar. Severity:	1 Necessary	Cost Estimate:	\$1,000.00
Implementation Priority:	4	Facility Function:	
Implementation Phase:		Implementation Date:	
Official Responsible:			
Notes:

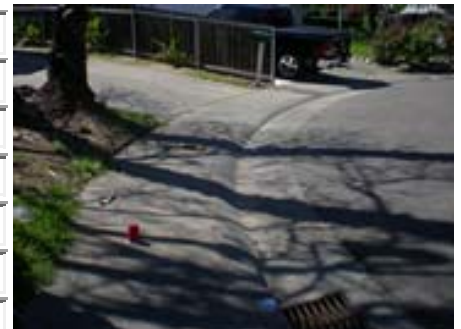
Field Date:	4/6/2011	Report Date:	4/6/2011	Barrier #:	6647A
Location:	Nettle Ct - South				
X Coordinate:	-121.2593				
Y Coordinate:	38.69598				
Barrier Area:	Sidewalks				
Barrier Type:	Cross Slope - Existing (3.1% to 4.0%)				
Code Ref:	CBC 1133B.7.1.3 and ADA/ABA 403.3

As Built Meas:	324	Quantity:	LF
Description:	Cross slope exceeds 2.0% (3.1% to 4.0%)		
As Built Desc:	3.7% cross slope		
Solution:	Demolish existing and construct new route		
Bar. Severity:	3 Hindrance	Cost Estimate:	\$40,500.00
Implementation Priority:	4	Facility Function:	
Implementation Phase:		Implementation Date:	
Official Responsible:			
Notes:

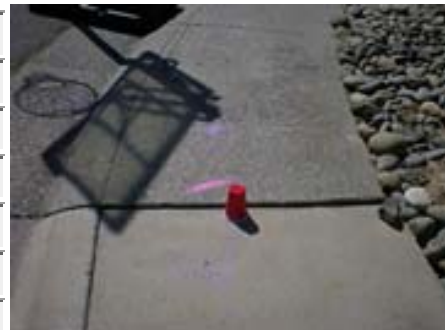
Field Date:	4/6/2011	Report Date:	4/6/2011	Barrier #:	6647B
Location:	Nettle Ct - South				
X Coordinate:	-121.25958				
Y Coordinate:	38.69615				
Barrier Area:	Sidewalks				
Barrier Type:	Abrupt Change in Level - > 1/2"				
Code Ref:	CBC 1133B.7.1 and ADA/ABA 303.3

As Built Meas:	4	Quantity:	LF
Description:	Change in level greater than 1/2"		
As Built Desc:	1/2" lip in sidewalk surface		
Solution:	Grind or repair sidewalk to remove trip hazard		
Bar. Severity:	1 Necessary	Cost Estimate:	\$1,000.00
Implementation Priority:	4	Facility Function:	
Implementation Phase:		Implementation Date:	
Official Responsible:			
Notes:

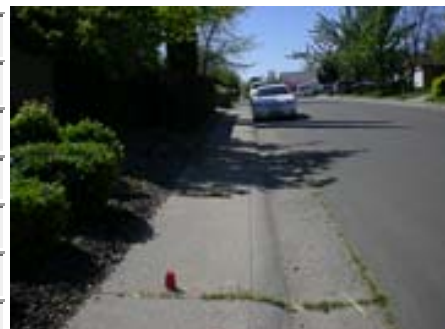
Field Date:	4/6/2011	Report Date:	4/6/2011	Barrier #:	6648
Location:	Yarrow Wy - East				
X Coordinate:	-121.2601				
Y Coordinate:	38.69616				
Barrier Area:	Sidewalks				
Barrier Type:	Cross Slope - Existing (4.1% to 4.9%)				
Code Ref:	CBC 1133B.7.1.3 and ADA/ABA 403.3

As Built Meas:	754	Quantity:	LF
Description:	Cross slope exceeds 2.0% (4.1% to 4.9%)		
As Built Desc:	4.1% cross slope		
Solution:	Demolish existing and construct new route		
Bar. Severity:	2 Recommended	Cost Estimate:	\$94,250.00
Implementation Priority:	4	Facility Function:	
Implementation Phase:		Implementation Date:	
Official Responsible:			
Notes:

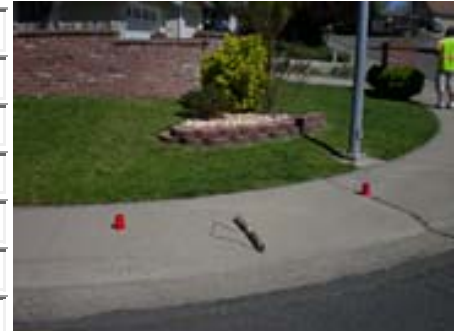
Field Date:	4/6/2011	Report Date:	4/6/2011	Barrier #:	6649
Location:	Stacey Hills - North				
X Coordinate:	-121.25906				
Y Coordinate:	38.69356				
Barrier Area:	Sidewalks				
Barrier Type:	Elbow in Sidewalk - Cross Slope (5.0% or more)				
Code Ref:	CBC 1133B.7.1.3 and ADA/ABA 403.3

As Built Meas:	6	Quantity:	LF
Description:	Cross slope at elbow exceeds 2.0% (5.0% or more)		
As Built Desc:	7.6% cross slope		
Solution:	Demolish existing and construct new sidewalk without curb ramp		
Bar. Severity:	1 Necessary	Cost Estimate:	\$750.00
Implementation Priority:	4	Facility Function:	
Implementation Phase:		Implementation Date:	
Official Responsible:			
Notes:

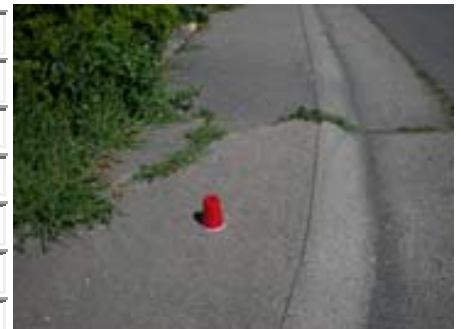
Field Date:	4/6/2011	Report Date:	4/6/2011	Barrier #:	6650
Location:	Cross Dr - West				
X Coordinate:	-121.25814				
Y Coordinate:	38.69429				
Barrier Area:	Sidewalks				
Barrier Type:	Surface Condition - Damaged				
Code Ref:	CBC 1133B.7.1 and ADA/ABA 302.1

As Built Meas:	4	Quantity:	LF
Description:	Surface is not firm and stable (cracked, broken or loose soil, etc.)		
As Built Desc:	Cracked concrete		
Solution:	Repair surface to make firm and stable		
Bar. Severity:	1 Necessary	Cost Estimate:	\$500.00
Implementation Priority:	4	Facility Function:	
Implementation Phase:		Implementation Date:	
Official Responsible:			
Notes:
