DRAFT ADA TRANSITION PLAN UPDATE
NEIGHBORHOOD AREA 9 SONA
SEPTEMBER 20, 2011

CITY OF CITRUS HEIGHTS

The Sunrise Oaks Neighborhood Association (SONA)

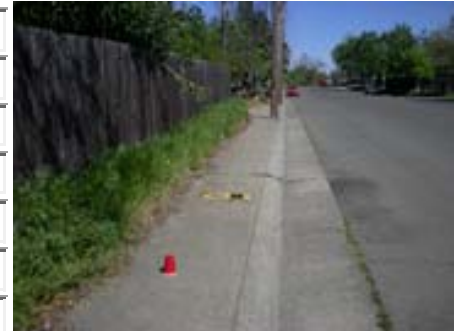
Field Date:	4/6/2011	Report Date:	4/6/2011	Barrier #:	6651A
Location:	Cross Dr - West				
X Coordinate:	-121.25813				
Y Coordinate:	38.69436				
Barrier Area:	Sidewalks				
Barrier Type:	Cross Slope - Existing (3.1% to 4.0%)				
Code Ref:	CBC 1133B.7.1.3 and ADA/ABA 403.3

As Built Meas:	122	Quantity:	LF
Description:	Cross slope exceeds 2.0% (3.1% to 4.0%)		
As Built Desc:	3.3% cross slope		
Solution:	Demolish existing and construct new route		
Bar. Severity:	3 Hindrance	Cost Estimate:	\$15,250.00
Implementation Priority:	4	Facility Function:	
Implementation Phase:		Implementation Date:	
Official Responsible:			
Notes:

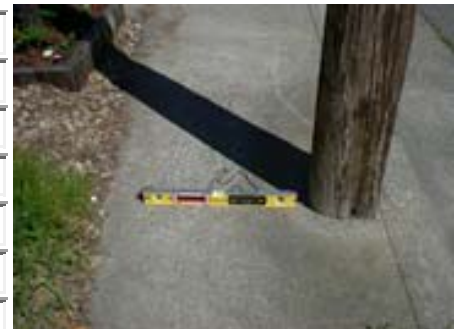
Field Date:	4/6/2011	Report Date:	4/6/2011	Barrier #:	6651B
Location:	Cross Dr - West				
X Coordinate:	-121.25811				
Y Coordinate:	38.69452				
Barrier Area:	Sidewalks				
Barrier Type:	Clear Width - Existing ($\leq 31"$ or less)				
Code Ref:	CBC 1133B.7.1

As Built Meas:	2	Quantity:	LF
Description:	Pedestrian route is not min. 48" wide ($\leq 31"$ or less)		
As Built Desc:	24" clear width due to pole		
Solution:	Demolish existing and construct new route		
Bar. Severity:	1 Necessary	Cost Estimate:	\$250.00
Implementation Priority:	4	Facility Function:	
Implementation Phase:		Implementation Date:	
Official Responsible:			
Notes:

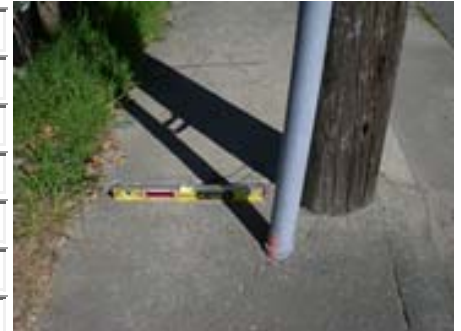
Field Date:	4/6/2011	Report Date:	4/6/2011	Barrier #:	6651C
Location:	Cross Dr - West				
X Coordinate:	-121.25814				
Y Coordinate:	38.69465				
Barrier Area:	Sidewalks				
Barrier Type:	Clear Width - Existing ($\leq 31"$ or less)				
Code Ref:	CBC 1133B.7.1

As Built Meas:	2	Quantity:	LF
Description:	Pedestrian route is not min. 48" wide ($\leq 31"$ or less)		
As Built Desc:	24" clear width due to pole		
Solution:	Demolish existing and construct new route		
Bar. Severity:	1 Necessary	Cost Estimate:	\$250.00
Implementation Priority:	4	Facility Function:	
Implementation Phase:		Implementation Date:	
Official Responsible:			
Notes:

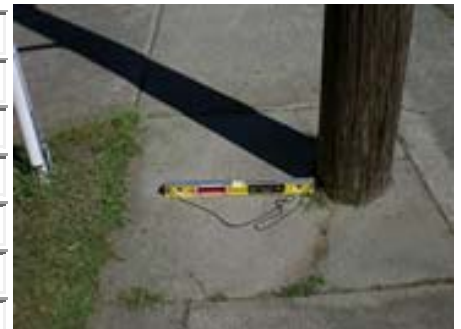
Field Date:	4/6/2011	Report Date:	4/6/2011	Barrier #:	6652
Location:	Cross Dr - West				
X Coordinate:	-121.25813				
Y Coordinate:	38.69541				
Barrier Area:	Sidewalks				
Barrier Type:	Clear Width - Existing ($\leq 31"$ or less)				
Code Ref:	CBC 1133B.7.1

As Built Meas:	2	Quantity:	LF
Description:	Pedestrian route is not min. 48" wide ($\leq 31"$ or less)		
As Built Desc:	24" clear width due to pole		
Solution:	Demolish existing and construct new route		
Bar. Severity:	1 Necessary	Cost Estimate:	\$250.00
Implementation Priority:	4	Facility Function:	
Implementation Phase:		Implementation Date:	
Official Responsible:			
Notes:

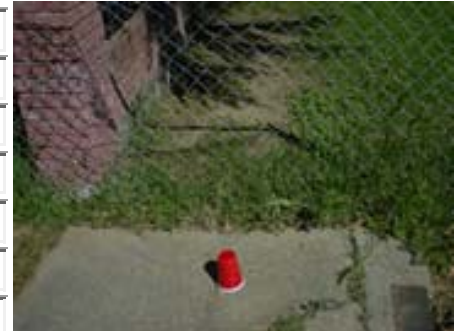
Field Date:	4/6/2011	Report Date:	4/6/2011	Barrier #:	6653
Location:	Cross Dr - West				
X Coordinate:	-121.25812				
Y Coordinate:	38.69554				
Barrier Area:	Sidewalks				
Barrier Type:	No Sidewalk - No Barricade				
Code Ref:	MUTCD Section 6D.01

As Built Meas:	1	Quantity:	JOB
Description:	No barricade provided where sidewalk ends in hazardous location		
As Built Desc:	No barricade or other warning provided for the visually impaired at end of sidewalk		
Solution:	Provide barricade with cane detectable warning at end of sidewalk		
Bar. Severity:	1 Necessary	Cost Estimate:	\$1,350.00
Implementation Priority:	4	Facility Function:	
Implementation Phase:		Implementation Date:	
Official Responsible:			
Notes:

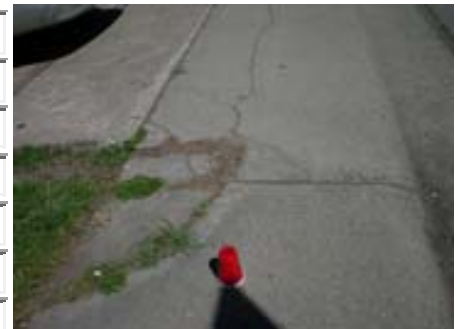
Field Date:	4/6/2011	Report Date:	4/6/2011	Barrier #:	6654
Location:	Cross Dr - West				
X Coordinate:	-121.25811				
Y Coordinate:	38.6956				
Barrier Area:	Sidewalks				
Barrier Type:	Surface Condition - Damaged				
Code Ref:	CBC 1133B.7.1 and ADA/ABA 302.1

As Built Meas:	4	Quantity:	LF
Description:	Surface is not firm and stable (cracked, broken or loose soil, etc.)		
As Built Desc:	Cracked concrete		
Solution:	Repair surface to make firm and stable		
Bar. Severity:	1 Necessary	Cost Estimate:	\$500.00
Implementation Priority:	4	Facility Function:	
Implementation Phase:		Implementation Date:	
Official Responsible:			
Notes:

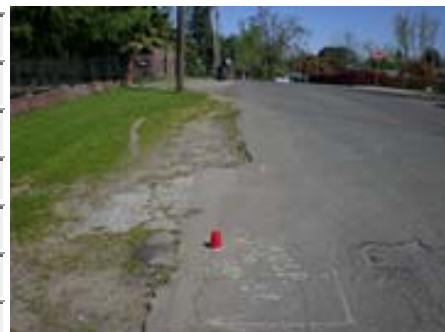
Field Date:	4/6/2011	Report Date:	4/6/2011	Barrier #:	6655
Location:	Cross Dr - West				
X Coordinate:	-121.25804				
Y Coordinate:	38.69563				
Barrier Area:	Sidewalks				
Barrier Type:	No sidewalk				
Code Ref:	CBC 1127B.1 and ADA/ABA 206.2.1

As Built Meas:	2596	Quantity:	LF
Description:	No pedestrian route provided		
As Built Desc:	No sidewalk provided		
Solution:	Construct new firm and stable pedestrian route		
Bar. Severity:	1 Necessary	Cost Estimate:	\$259,600.00
Implementation Priority:	4	Facility Function:	
Implementation Phase:		Implementation Date:	
Official Responsible:			
Notes:

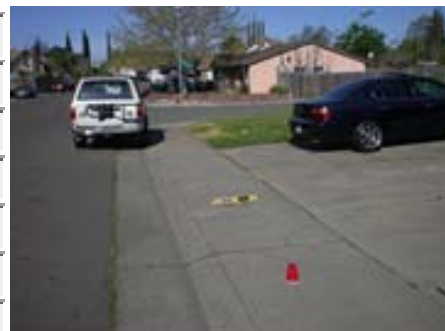
Field Date:	4/7/2011	Report Date:	4/8/2011	Barrier #:	6656
Location:	San Cosme Dr - North				
X Coordinate:	-121.26316				
Y Coordinate:	38.69726				
Barrier Area:	Sidewalks				
Barrier Type:	Cross Slope - Existing (4.1% to 4.9%)				
Code Ref:	CBC 1133B.7.1.3 and ADA/ABA 403.3

As Built Meas:	49	Quantity:	LF
Description:	Cross slope exceeds 2.0% (4.1% to 4.9%)		
As Built Desc:	4.1% cross slope		
Solution:	Demolish existing and construct new route		
Bar. Severity:	2 Recommended	Cost Estimate:	\$6,125.00
Implementation Priority:	4	Facility Function:	
Implementation Phase:		Implementation Date:	
Official Responsible:			
Notes:

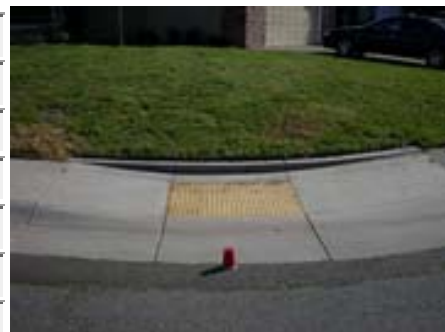
Field Date:	4/7/2011	Report Date:	4/8/2011	Barrier #:	6657
Location:	San Cosme Dr and Single Wy - Corner B				
X Coordinate:	-121.2633				
Y Coordinate:	38.69727				
Barrier Area:	Curb Ramps				
Barrier Type:	12" Grooves - Existing (3.1% to 4.0%)				
Code Ref:	CBC 1127B.5.6

As Built Meas:	1	Quantity:	EACH
Description:	12" grooves at top of curb ramp are not level (3.1% to 4.0%)		
As Built Desc:	3.6% at 12" grooves		
Solution:	Demolish existing and construct new curb ramp		
Bar. Severity:	3 Hindrance	Cost Estimate:	\$2,500.00
Implementation Priority:	4	Facility Function:	
Implementation Phase:		Implementation Date:	
Official Responsible:			
Notes:	Two - way intersection corners A, B. Corner A compliant

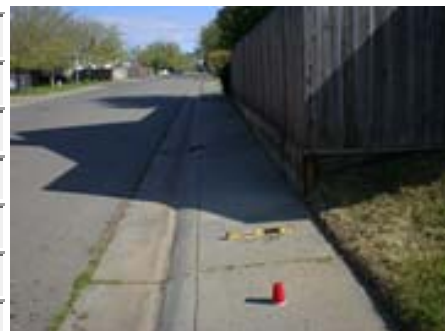
Field Date:	4/7/2011	Report Date:	4/8/2011	Barrier #:	6658
Location:	Single Wy - East				
X Coordinate:	-121.2633				
Y Coordinate:	38.69741				
Barrier Area:	Sidewalks				
Barrier Type:	Cross Slope - Existing (4.1% to 4.9%)				
Code Ref:	CBC 1133B.7.1.3 and ADA/ABA 403.3

As Built Meas:	1051	Quantity:	LF
Description:	Cross slope exceeds 2.0% (4.1% to 4.9%)		
As Built Desc:	4.6% cross slope		
Solution:	Demolish existing and construct new route		
Bar. Severity:	2 Recommended	Cost Estimate:	\$131,375.00
Implementation Priority:	4	Facility Function:	
Implementation Phase:		Implementation Date:	
Official Responsible:			
Notes:

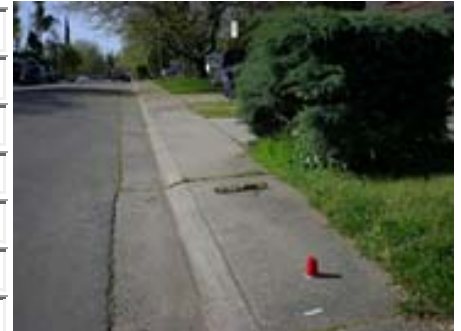
Field Date:	4/7/2011	Report Date:	4/8/2011	Barrier #:	6659
Location:	Single Wy - West				
X Coordinate:	-121.26356				
Y Coordinate:	38.70018				
Barrier Area:	Sidewalks				
Barrier Type:	Cross Slope - Existing (4.1% to 4.9%)				
Code Ref:	CBC 1133B.7.1.3 and ADA/ABA 403.3

As Built Meas:	829	Quantity:	LF
Description:	Cross slope exceeds 2.0% (4.1% to 4.9%)		
As Built Desc:	4.5% cross slope		
Solution:	Demolish existing and construct new route		
Bar. Severity:	2 Recommended	Cost Estimate:	\$103,625.00
Implementation Priority:	4	Facility Function:	
Implementation Phase:		Implementation Date:	
Official Responsible:

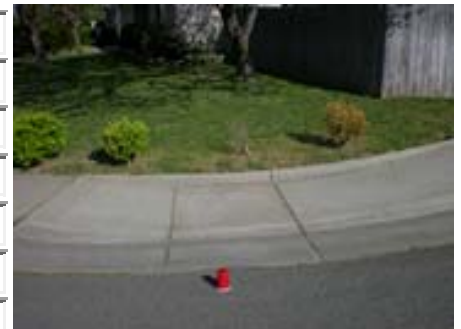
Field Date:	4/7/2011	Report Date:	4/8/2011	Barrier #:	6660A
Location:	Single Wy and Dana Butte Wy - Corner A				
X Coordinate:	-121.26352				
Y Coordinate:	38.69796				
Barrier Area:	Curb Ramps				
Barrier Type:	12" Grooves - Existing (3.1% to 4.0%)				
Code Ref:	CBC 1127B.5.6

As Built Meas:	1	Quantity:	EACH
Description:	12" grooves at top of curb ramp are not level (3.1% to 4.0%)		
As Built Desc:	3.4% at 12" grooves		
Solution:	Demolish existing and construct new curb ramp		
Bar. Severity:	3 Hindrance	Cost Estimate:	\$2,500.00
Implementation Priority:	4	Facility Function:	
Implementation Phase:		Implementation Date:	
Official Responsible:

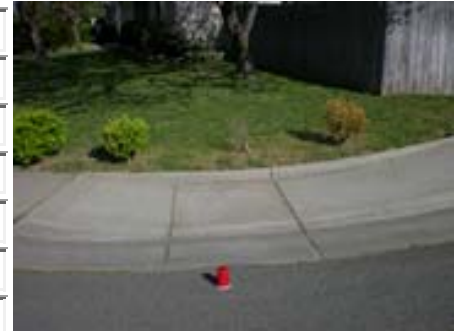
Field Date:	4/7/2011	Report Date:	4/8/2011	Barrier #:	6660B
Location:	Single Wy and Dana Butte Wy - Corner A				
X Coordinate:	-121.26352				
Y Coordinate:	38.69796				
Barrier Area:	Curb Ramps				
Barrier Type:	Parallel Ramp Landing - Existing (3.1% to 4.0%)				
Code Ref:	CBC 1127B.5.4 and ADA/ABA 406.4

As Built Meas:	1	Quantity:	EACH
Description:	Curb ramp landing or pan not level (3.1% to 4.0%)		
As Built Desc:	3.8% landing slope		
Solution:	Demolish existing and construct new transition		
Bar. Severity:	3 Hindrance	Cost Estimate:	\$0.00
Implementation Priority:	4	Facility Function:	
Implementation Phase:		Implementation Date:	
Official Responsible:			
Notes:	Two - way intersection corners A, D

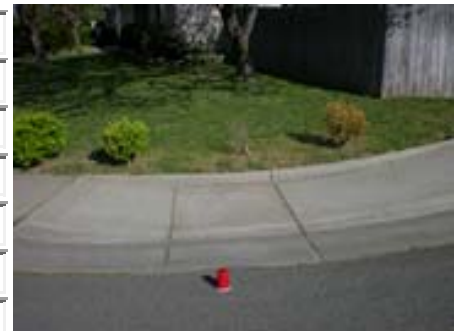
Field Date:	4/7/2011	Report Date:	4/8/2011	Barrier #:	6660C
Location:	Single Wy and Dana Butte Wy - Corner A				
X Coordinate:	-121.26352				
Y Coordinate:	38.69796				
Barrier Area:	Curb Ramps				
Barrier Type:	Detectable Warnings - Truncated Domes				
Code Ref:	CBC 1127B.5.7 and ADA/ABA 705.1.3

As Built Meas:	1	Quantity:	EACH
Description:	No truncated domes provided at curb ramp		
As Built Desc:	No detectable warnings at curb ramp		
Solution:	Provide compliant truncated domes		
Bar. Severity:	2 Recommended	Cost Estimate:	\$0.00
Implementation Priority:	4	Facility Function:	
Implementation Phase:		Implementation Date:	
Official Responsible:			
Notes:	Two - way intersection corners A, D

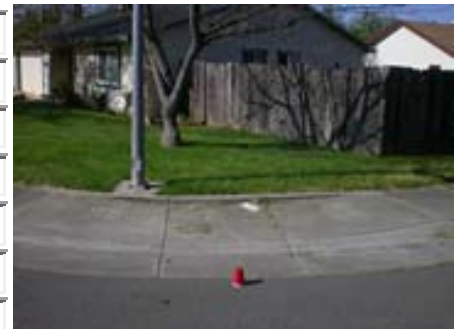
Barrier Type: Parallel Ramp Landing - Existing (2.1% to 3.0%)

Code Ref: CBC 1127B.5.4 and ADA/ABA 406.4

Description: Curb ramp landing or pan not level (2.1% to 3.0%)

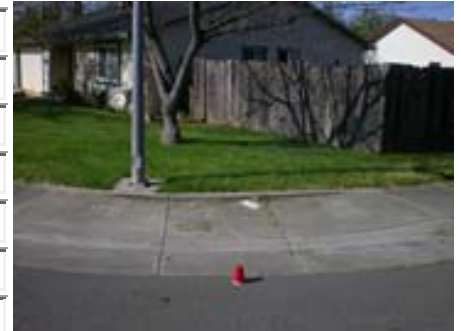
Barrier Type: Detectable Warnings - Truncated Domes

Code Ref: CBC 1127B.5.7 and ADA/ABA 705.1.3

Description: No truncated domes provided at curb ramp

Bar. Severity: 2 Recommended Cost Estimate: \$1,400.00 Status:

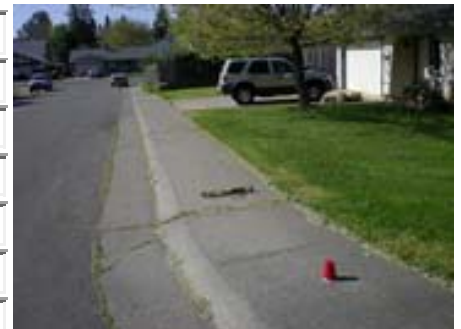
Barrier Type: Cross Slope - Existing (3.1% to 4.0%)

Code Ref: CBC 1133B.7.1.3 and ADA/ABA 403.3

Description: Cross slope exceeds 2.0% (3.1% to 4.0%)

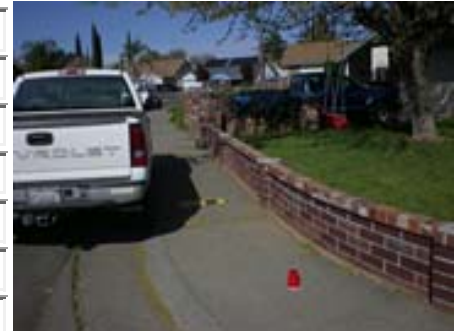
Field Date:	4/7/2011	Report Date:	4/8/2011	Barrier #:	6663
Location:	San Cosme Dr - North				
X Coordinate:	-121.26351				
Y Coordinate:	38.69728				
Barrier Area:	Sidewalks				
Barrier Type:	Cross Slope - Existing (5.0% or more)				
Code Ref:	CBC 1133B.7.1.3 and ADA/ABA 403.3

As Built Meas:	638	Quantity:	LF
Description:	Cross slope exceeds 2.0% (5.0% or more)		
As Built Desc:	5.1% cross slope		
Solution:	Demolish existing and construct new route		
Bar. Severity:	1 Necessary	Cost Estimate:	\$79,750.00
Implementation Priority:	4	Facility Function:	
Implementation Phase:		Implementation Date:	
Official Responsible:

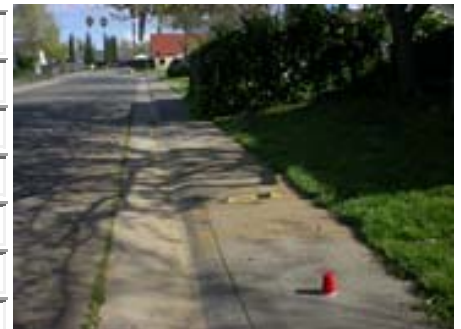
Field Date:	4/7/2011	Report Date:	4/8/2011	Barrier #:	6664
Location:	Alma Mesa Wy - East				
X Coordinate:	-121.26539				
Y Coordinate:	38.69823				
Barrier Area:	Sidewalks				
Barrier Type:	Cross Slope - Existing (3.1% to 4.0%)				
Code Ref:	CBC 1133B.7.1.3 and ADA/ABA 403.3

As Built Meas:	210	Quantity:	LF
Description:	Cross slope exceeds 2.0% (3.1% to 4.0%)		
As Built Desc:	4.0% cross slope		
Solution:	Demolish existing and construct new route		
Bar. Severity:	3 Hindrance	Cost Estimate:	\$26,250.00
Implementation Priority:	4	Facility Function:	
Implementation Phase:		Implementation Date:	
Official Responsible:

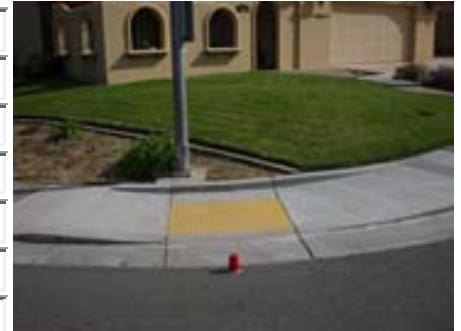
Field Date:	4/7/2011	Report Date:	4/8/2011	Barrier #:	6665
Location:	Alma Mesa Wy and Dana Butte Wy - Corner B				
X Coordinate:	-121.26549				
Y Coordinate:	38.69891				
Barrier Area:	Curb Ramps				
Barrier Type:	12" Grooves - Existing (4.1% to 4.9%)				
Code Ref:	CBC 1127B.5.6

As Built Meas:	1	Quantity:	EACH
Description:	12" grooves at top of curb ramp are not level (4.1% to 4.9%)		
As Built Desc:	4.1% at 12" grooves		
Solution:	Demolish existing and construct new curb ramp		
Bar. Severity:	2 Recommended	Cost Estimate:	\$2,500.00
Implementation Priority:	4	Facility Function:	
Implementation Phase:		Implementation Date:	
Official Responsible:			
Notes:	Four - way intersection corners A,B,C,D. Corners A,C,D compliant

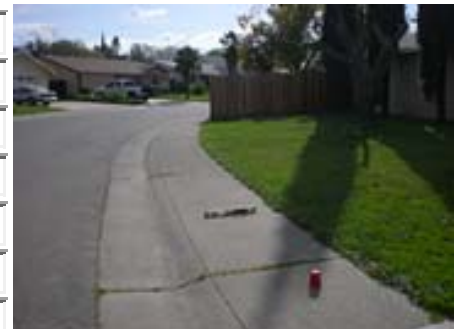
Field Date:	4/7/2011	Report Date:	4/8/2011	Barrier #:	6666
Location:	Dana Butte Wy - South				
X Coordinate:	-121.26528				
Y Coordinate:	38.69883				
Barrier Area:	Sidewalks				
Barrier Type:	Cross Slope - Existing (3.1% to 4.0%)				
Code Ref:	CBC 1133B.7.1.3 and ADA/ABA 403.3

As Built Meas:	648	Quantity:	LF
Description:	Cross slope exceeds 2.0% (3.1% to 4.0%)		
As Built Desc:	4.0% cross slope		
Solution:	Demolish existing and construct new route		
Bar. Severity:	3 Hindrance	Cost Estimate:	\$81,000.00
Implementation Priority:	4	Facility Function:	
Implementation Phase:		Implementation Date:	
Official Responsible:			
Notes:

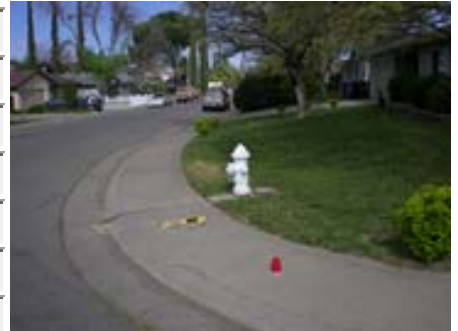
Field Date:	4/7/2011	Report Date:	4/8/2011	Barrier #:	6667
Location:	Dana Butte Wy - North				
X Coordinate:	-121.26356				
Y Coordinate:	38.69796				
Barrier Area:	Sidewalks				
Barrier Type:	Cross Slope - Existing (5.0% or more)				
Code Ref:	CBC 1133B.7.1.3 and ADA/ABA 403.3

As Built Meas:	659	Quantity:	LF
Description:	Cross slope exceeds 2.0% (5.0% or more)		
As Built Desc:	5.3% cross slope		
Solution:	Demolish existing and construct new route		
Bar. Severity:	1 Necessary	Cost Estimate:	\$82,375.00
Implementation Priority:	4	Facility Function:	
Implementation Phase:		Implementation Date:	
Official Responsible:

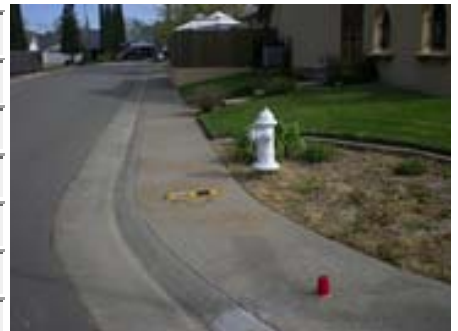
Field Date:	4/7/2011	Report Date:	4/8/2011	Barrier #:	6668
Location:	Alma Mesa Wy - East				
X Coordinate:	-121.2654				
Y Coordinate:	38.69901				
Barrier Area:	Sidewalks				
Barrier Type:	Cross Slope - Existing (3.1% to 4.0%)				
Code Ref:	CBC 1133B.7.1.3 and ADA/ABA 403.3

As Built Meas:	240	Quantity:	LF
Description:	Cross slope exceeds 2.0% (3.1% to 4.0%)		
As Built Desc:	3.9% cross slope		
Solution:	Demolish existing and construct new route		
Bar. Severity:	3 Hindrance	Cost Estimate:	\$30,000.00
Implementation Priority:	4	Facility Function:	
Implementation Phase:		Implementation Date:	
Official Responsible:

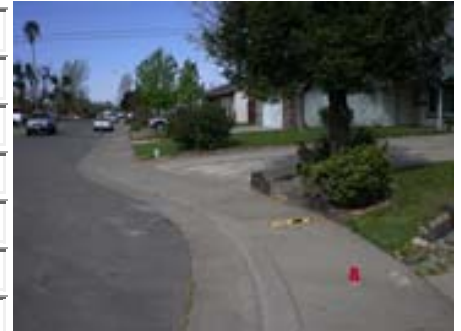
Field Date:	4/7/2011	Report Date:	4/8/2011	Barrier #:	6669A
Location:	Alma Mesa Wy - North				
X Coordinate:	-121.26561				
Y Coordinate:	38.69972				
Barrier Area:	Sidewalks				
Barrier Type:	Cross Slope - Existing (4.1% to 4.9%)				
Code Ref:	CBC 1133B.7.1.3 and ADA/ABA 403.3

As Built Meas:	845	Quantity:	LF
Description:	Cross slope exceeds 2.0% (4.1% to 4.9%)		
As Built Desc:	4.5% cross slope		
Solution:	Demolish existing and construct new route		
Bar. Severity:	2 Recommended	Cost Estimate:	\$105,625.00
Implementation Priority:	4	Facility Function:	
Implementation Phase:		Implementation Date:	
Official Responsible:			
Notes:

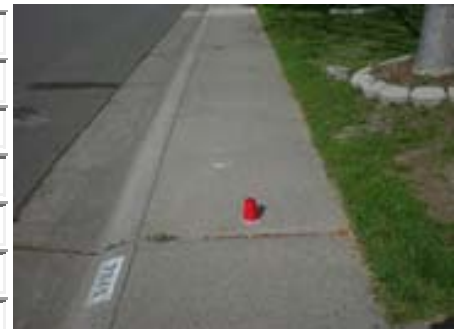
Field Date:	4/7/2011	Report Date:	4/8/2011	Barrier #:	6669B
Location:	Alma Mesa Wy - North				
X Coordinate:	-121.26752				
Y Coordinate:	38.69967				
Barrier Area:	Sidewalks				
Barrier Type:	Abrupt Change in Level - > 1/2"				
Code Ref:	CBC 1133B.7.1 and ADA/ABA 303.3

As Built Meas:	4	Quantity:	LF
Description:	Change in level greater than 1/2"		
As Built Desc:	1/2" lip in sidewalk surface		
Solution:	Grind or repair sidewalk to remove trip hazard		
Bar. Severity:	1 Necessary	Cost Estimate:	\$1,000.00
Implementation Priority:	4	Facility Function:	
Implementation Phase:		Implementation Date:	
Official Responsible:			
Notes:

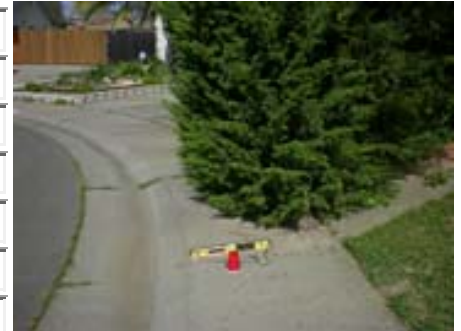
Field Date:	4/7/2011	Report Date:	4/8/2011	Barrier #:	6669C
Location:	Alma Mesa Wy - North				
X Coordinate:	-121.26842				
Y Coordinate:	38.69968				
Barrier Area:	Sidewalks				
Barrier Type:	Clear Width - Existing ($\leq 31"$ or less)				
Code Ref:	CBC 1133B.7.1

As Built Meas:	1	Quantity:	LF
Description:	Pedestrian route is not min. 48" wide ($\leq 31"$ or less)		
As Built Desc:	8" clear width due to foliage		
Solution:	Trim foliage to provide min. 48" clear width		
Bar. Severity:	1 Necessary	Cost Estimate:	\$125.00
Implementation Priority:	4	Facility Function:	
Implementation Phase:		Implementation Date:	
Official Responsible:			
Notes:

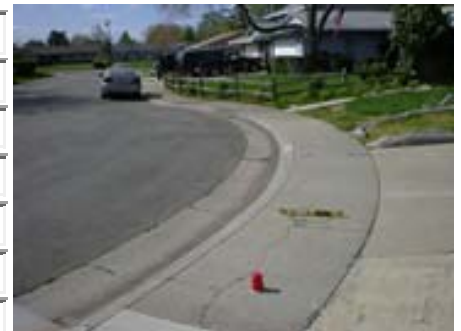
Field Date:	4/7/2011	Report Date:	4/8/2011	Barrier #:	6670
Location:	Alma Mesa Wy - West				
X Coordinate:	-121.26859				
Y Coordinate:	38.69962				
Barrier Area:	Sidewalks				
Barrier Type:	Cross Slope - Existing (5.0% or more)				
Code Ref:	CBC 1133B.7.1.3 and ADA/ABA 403.3

As Built Meas:	275	Quantity:	LF
Description:	Cross slope exceeds 2.0% (5.0% or more)		
As Built Desc:	5.0% cross slope		
Solution:	Demolish existing and construct new route		
Bar. Severity:	1 Necessary	Cost Estimate:	\$34,375.00
Implementation Priority:	4	Facility Function:	
Implementation Phase:		Implementation Date:	
Official Responsible:			
Notes:

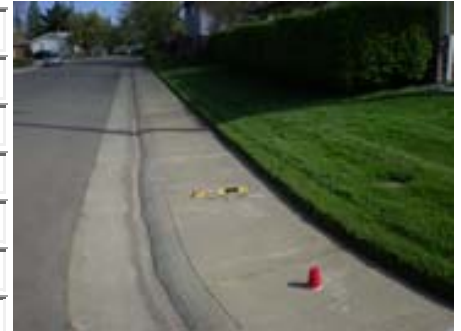
Field Date:	4/7/2011	Report Date:	4/8/2011	Barrier #:	6671
Location:	Alma Mesa Wy - East				
X Coordinate:	-121.26837				
Y Coordinate:	38.69895				
Barrier Area:	Sidewalks				
Barrier Type:	Cross Slope - Existing (4.1% to 4.9%)				
Code Ref:	CBC 1133B.7.1.3 and ADA/ABA 403.3

As Built Meas:	210	Quantity:	LF
Description:	Cross slope exceeds 2.0% (4.1% to 4.9%)		
As Built Desc:	4.5% cross slope		
Solution:	Demolish existing and construct new route		
Bar. Severity:	2 Recommended	Cost Estimate:	\$26,250.00
Status:			
Implementation Priority:	4	Facility Function:	
Implementation Phase:		Implementation Date:	
Official Responsible:

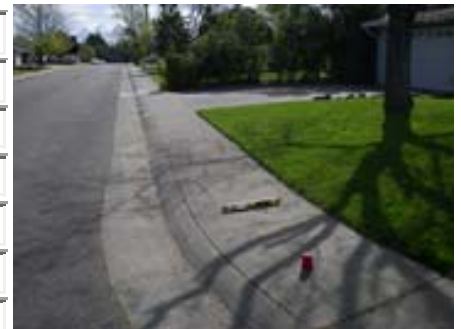
Field Date:	4/7/2011	Report Date:	4/8/2011	Barrier #:	6672A
Location:	Alma Mesa Wy - South				
X Coordinate:	-121.26832				
Y Coordinate:	38.69947				
Barrier Area:	Sidewalks				
Barrier Type:	Cross Slope - Existing (4.1% to 4.9%)				
Code Ref:	CBC 1133B.7.1.3 and ADA/ABA 403.3

As Built Meas:	747	Quantity:	LF
Description:	Cross slope exceeds 2.0% (4.1% to 4.9%)		
As Built Desc:	4.6% cross slope		
Solution:	Demolish existing and construct new route		
Bar. Severity:	2 Recommended	Cost Estimate:	\$93,375.00
Status:			
Implementation Priority:	4	Facility Function:	
Implementation Phase:		Implementation Date:	
Official Responsible:

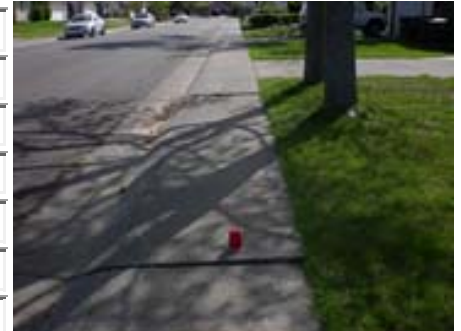
Field Date:	4/7/2011	Report Date:	4/8/2011	Barrier #:	6672B
Location:	Alma Mesa Wy - South				
X Coordinate:	-121.26718				
Y Coordinate:	38.69954				
Barrier Area:	Sidewalks				
Barrier Type:	Abrupt Change in Level - Tree Heaves				
Code Ref:	CBC 1133B.7.1 and ADA/ABA 303.3

As Built Meas:	12	Quantity:	LF
Description:	Change in level greater than 1/2"		
As Built Desc:	5/8" lip due to tree heaves		
Solution:	Grind or repair sidewalk to remove trip hazard		
Bar. Severity:	1 Necessary	Cost Estimate:	\$3,000.00
Implementation Priority:	4	Facility Function:	
Implementation Phase:		Implementation Date:	
Official Responsible:			
Notes:

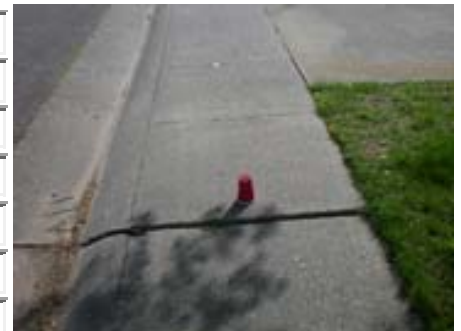
Field Date:	4/7/2011	Report Date:	4/8/2011	Barrier #:	6672C
Location:	Alma Mesa Wy - South				
X Coordinate:	-121.2671				
Y Coordinate:	38.69953				
Barrier Area:	Sidewalks				
Barrier Type:	Abrupt Change in Level - > 1/2"				
Code Ref:	CBC 1133B.7.1 and ADA/ABA 303.3

As Built Meas:	4	Quantity:	LF
Description:	Change in level greater than 1/2"		
As Built Desc:	1/2" lip in sidewalk surface		
Solution:	Grind or repair sidewalk to remove trip hazard		
Bar. Severity:	1 Necessary	Cost Estimate:	\$1,000.00
Implementation Priority:	4	Facility Function:	
Implementation Phase:		Implementation Date:	
Official Responsible:			
Notes:

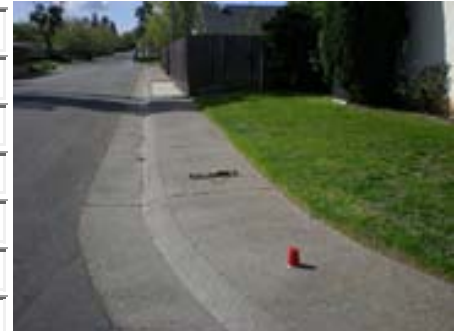
Field Date:	4/7/2011	Report Date:	4/8/2011	Barrier #:	6673
Location:	Alma Mesa Wy - West				
X Coordinate:	-121.26562				
Y Coordinate:	38.69954				
Barrier Area:	Sidewalks				
Barrier Type:	Cross Slope - Existing (3.1% to 4.0%)				
Code Ref:	CBC 1133B.7.1.3 and ADA/ABA 403.3

As Built Meas:	58	Quantity:	LF
Description:	Cross slope exceeds 2.0% (3.1% to 4.0%)		
As Built Desc:	3.9% cross slope		
Solution:	Demolish existing and construct new route		
Bar. Severity:	3 Hindrance	Cost Estimate:	\$7,250.00
Implementation Priority:	4	Facility Function:	
Implementation Phase:		Implementation Date:	
Official Responsible:			
Notes:

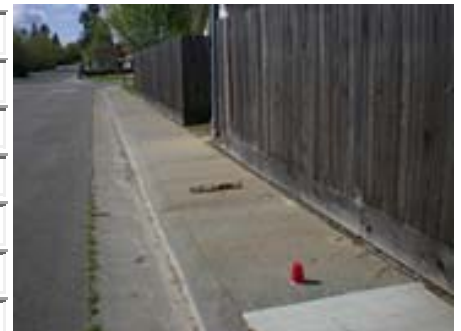
Field Date:	4/7/2011	Report Date:	4/8/2011	Barrier #:	6674
Location:	Alma Mesa Wy - West				
X Coordinate:	-121.26562				
Y Coordinate:	38.69933				
Barrier Area:	Sidewalks				
Barrier Type:	Cross Slope - Existing (3.1% to 4.0%)				
Code Ref:	CBC 1133B.7.1.3 and ADA/ABA 403.3

As Built Meas:	124	Quantity:	LF
Description:	Cross slope exceeds 2.0% (3.1% to 4.0%)		
As Built Desc:	3.8% cross slope		
Solution:	Demolish existing and construct new route		
Bar. Severity:	3 Hindrance	Cost Estimate:	\$15,500.00
Implementation Priority:	4	Facility Function:	
Implementation Phase:		Implementation Date:	
Official Responsible:			
Notes:

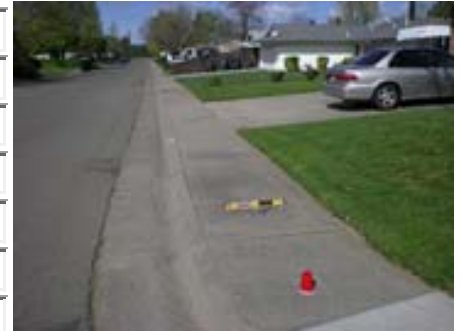
Field Date:	4/7/2011	Report Date:	4/8/2011	Barrier #:	6675
Location:	Dana Butte Wy - North				
X Coordinate:	-121.26568				
Y Coordinate:	38.69892				
Barrier Area:	Sidewalks				
Barrier Type:	Cross Slope - Existing (5.0% or more)				
Code Ref:	CBC 1133B.7.1.3 and ADA/ABA 403.3

As Built Meas:	764	Quantity:	LF
Description:	Cross slope exceeds 2.0% (5.0% or more)		
As Built Desc:	5.3% cross slope		
Solution:	Demolish existing and construct new route		
Bar. Severity:	1 Necessary	Cost Estimate:	\$95,500.00
Implementation Priority:	4	Facility Function:	
Implementation Phase:		Implementation Date:	
Official Responsible:

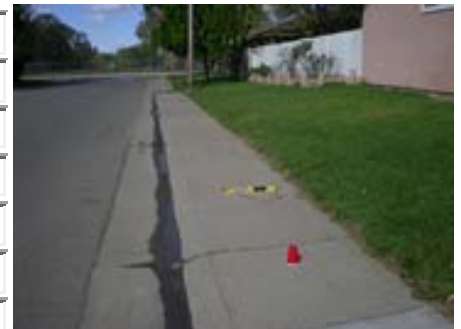
Field Date:	4/7/2011	Report Date:	4/8/2011	Barrier #:	6676
Location:	Dana Butte Wy - North				
X Coordinate:	-121.26868				
Y Coordinate:	38.69892				
Barrier Area:	Sidewalks				
Barrier Type:	Cross Slope - Existing (5.0% or more)				
Code Ref:	CBC 1133B.7.1.3 and ADA/ABA 403.3

As Built Meas:	177	Quantity:	LF
Description:	Cross slope exceeds 2.0% (5.0% or more)		
As Built Desc:	5.3% cross slope		
Solution:	Demolish existing and construct new route		
Bar. Severity:	1 Necessary	Cost Estimate:	\$22,125.00
Implementation Priority:	4	Facility Function:	
Implementation Phase:		Implementation Date:	
Official Responsible:

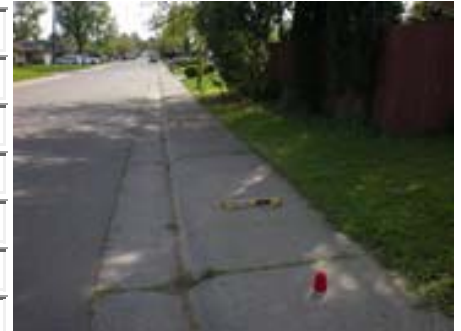
Barrier Type: Cross Slope - Existing (5.0% or more)

Code Ref: CBC 1133B.7.1.3 and ADA/ABA 403.3

Description: Cross slope exceeds 2.0% (5.0% or more)

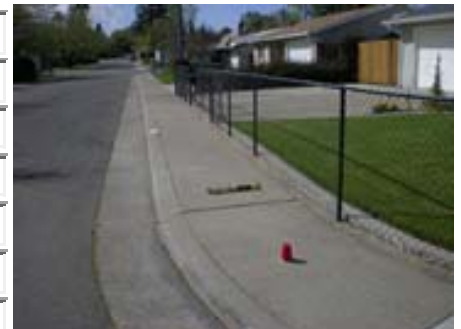
Barrier Type: Cross Slope - Existing (4.1% to 4.9%)

Code Ref: CBC 1133B.7.1.3 and ADA/ABA 403.3

Description: Cross slope exceeds 2.0% (4.1% to 4.9%)

Bar. Severity: 2 Recommended Cost Estimate: \$26,000.00 Status:

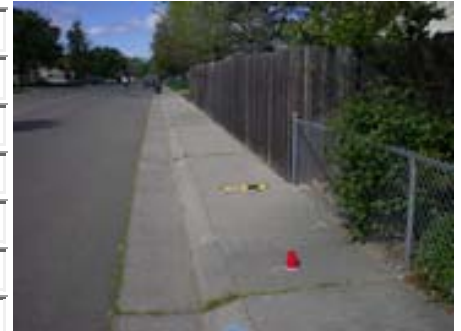
Field Date:	4/7/2011	Report Date:	4/8/2011	Barrier #:	6679A
Location:	San Cosme Dr - North				
X Coordinate:	-121.26563				
Y Coordinate:	38.69814				
Barrier Area:	Sidewalks				
Barrier Type:	Cross Slope - Existing (5.0% or more)				
Code Ref:	CBC 1133B.7.1.3 and ADA/ABA 403.3

As Built Meas:	1027	Quantity:	LF
Description:	Cross slope exceeds 2.0% (5.0% or more)		
As Built Desc:	5.3% cross slope		
Solution:	Demolish existing and construct new route		
Bar. Severity:	1 Necessary	Cost Estimate:	\$128,375.00
Implementation Priority:	4	Facility Function:	
Implementation Phase:		Implementation Date:	
Official Responsible:

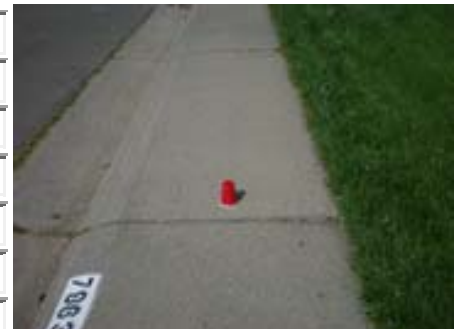
Field Date:	4/7/2011	Report Date:	4/8/2011	Barrier #:	6679B
Location:	San Cosme Dr - North				
X Coordinate:	-121.26836				
Y Coordinate:	38.69812				
Barrier Area:	Sidewalks				
Barrier Type:	Abrupt Change in Level - > 1/2"				
Code Ref:	CBC 1133B.7.1 and ADA/ABA 303.3

As Built Meas:	4	Quantity:	LF
Description:	Change in level greater than 1/2"		
As Built Desc:	1/2" lip in sidewalk surface		
Solution:	Grind or repair sidewalk to remove trip hazard		
Bar. Severity:	1 Necessary	Cost Estimate:	\$1,000.00
Implementation Priority:	4	Facility Function:	
Implementation Phase:		Implementation Date:	
Official Responsible:

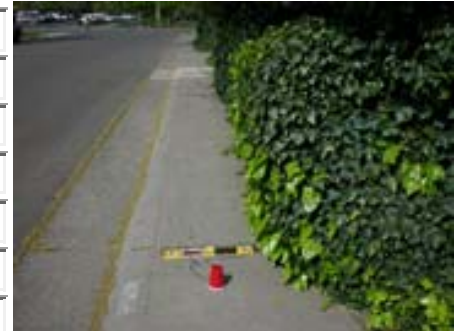
Field Date:	4/7/2011	Report Date:	4/8/2011	Barrier #:	6679C
Location:	San Cosme Dr - North				
X Coordinate:	-121.2686				
Y Coordinate:	38.69811				
Barrier Area:	Sidewalks				
Barrier Type:	Clear Width - Existing ($\leq 31"$ or less)				
Code Ref:	CBC 1133B.7.1

As Built Meas:	1	Quantity:	LF
Description:	Pedestrian route is not min. 48" wide ($\leq 31"$ or less)		
As Built Desc:	24" clear width due to foliage		
Solution:	Trim foliage to provide min. 48" clear width		
Bar. Severity:	1 Necessary	Cost Estimate:	\$125.00
Implementation Priority:	4	Facility Function:	
Implementation Phase:		Implementation Date:	
Official Responsible:			
Notes:

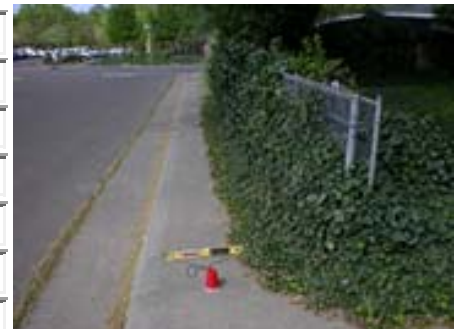
Field Date:	4/7/2011	Report Date:	4/8/2011	Barrier #:	6679D
Location:	San Cosme Dr - North				
X Coordinate:	-121.26879				
Y Coordinate:	38.69812				
Barrier Area:	Sidewalks				
Barrier Type:	Clear Width - Existing ($\leq 31"$ or less)				
Code Ref:	CBC 1133B.7.1

As Built Meas:	1	Quantity:	LF
Description:	Pedestrian route is not min. 48" wide ($\leq 31"$ or less)		
As Built Desc:	24" clear width due to foliage		
Solution:	Trim foliage to provide min. 48" clear width		
Bar. Severity:	1 Necessary	Cost Estimate:	\$125.00
Implementation Priority:	4	Facility Function:	
Implementation Phase:		Implementation Date:	
Official Responsible:			
Notes:

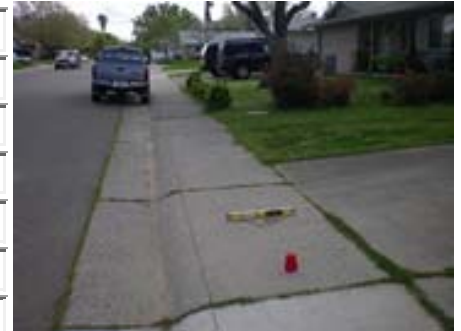
Barrier Type: Cross Slope - Existing (4.1% to 4.9%)

Code Ref: CBC 1133B.7.1.3 and ADA/ABA 403.3

As Built Meas: 189 Quantity: LF

Description: Cross slope exceeds 2.0% (4.1% to 4.9%)

Bar. Severity: 2 Recommended Cost Estimate: \$23,625.00 Status:

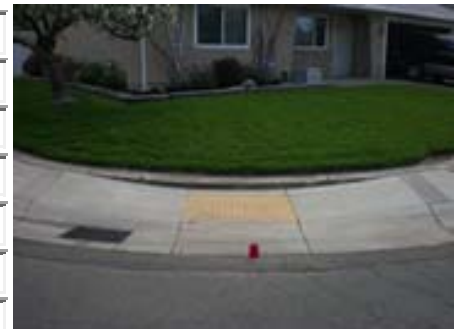
Barrier Type: 12" Grooves - Existing (4.1% to 4.9%)

Code Ref: CBC 1127B.5.6

As Built Meas: 1 Quantity: EACH

Description: 12" grooves at top of curb ramp are not level (4.1% to 4.9%)

Bar. Severity: 2 Recommended Cost Estimate: \$2,500.00 Status:

Notes: Two - way intersection corners C, D. Corner D compliant

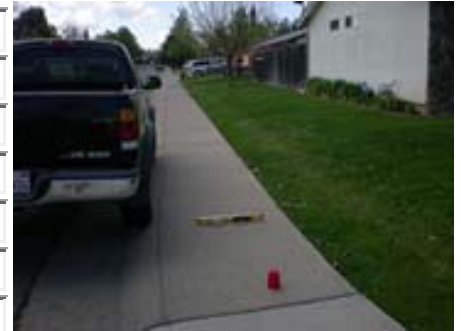
Field Date:	4/7/2011	Report Date:	4/8/2011	Barrier #:	6682
Location:	Camel Rock Wy - West				
X Coordinate:	-121.26845				
Y Coordinate:	38.69792				
Barrier Area:	Sidewalks				
Barrier Type:	Cross Slope - Existing (3.1% to 4.0%)				
Code Ref:	CBC 1133B.7.1.3 and ADA/ABA 403.3

As Built Meas:	549	Quantity:	LF
Description:	Cross slope exceeds 2.0% (3.1% to 4.0%)		
As Built Desc:	3.6% cross slope		
Solution:	Demolish existing and construct new route		
Bar. Severity:	3 Hindrance	Cost Estimate:	\$68,625.00
Implementation Priority:	4	Facility Function:	
Implementation Phase:		Implementation Date:	
Official Responsible:

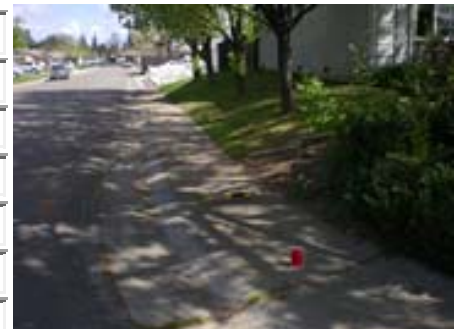
Field Date:	4/7/2011	Report Date:	4/8/2011	Barrier #:	6683
Location:	Camel Rock Wy - East				
X Coordinate:	-121.26827				
Y Coordinate:	38.69651				
Barrier Area:	Sidewalks				
Barrier Type:	Cross Slope - Existing (4.1% to 4.9%)				
Code Ref:	CBC 1133B.7.1.3 and ADA/ABA 403.3

As Built Meas:	267	Quantity:	LF
Description:	Cross slope exceeds 2.0% (4.1% to 4.9%)		
As Built Desc:	4.6% cross slope		
Solution:	Demolish existing and construct new route		
Bar. Severity:	2 Recommended	Cost Estimate:	\$33,375.00
Implementation Priority:	4	Facility Function:	
Implementation Phase:		Implementation Date:	
Official Responsible:

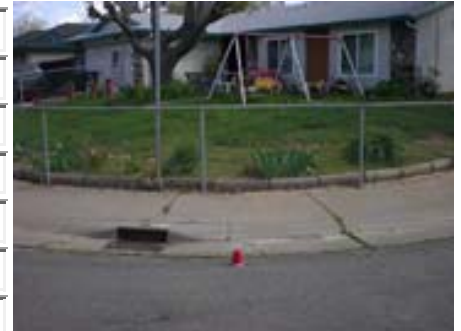
Field Date:	4/7/2011	Report Date:	4/8/2011	Barrier #:	6684
Location:	Camel Rock Wy and Escalante Wy - Corner B				
X Coordinate:	-121.26832				
Y Coordinate:	38.69738				
Barrier Area:	Curb Ramps				
Barrier Type:	No Curb Ramp				
Code Ref:	CBC 1127B.5.1 and ADA/ABA 402.2

As Built Meas:	1	Quantity:	EACH
Description:	No curb cut at corner (intersection)		
As Built Desc:	No curb ramp at corner		
Solution:	Demolish existing and construct curb cut		
Bar. Severity:	1 Necessary	Cost Estimate:	\$2,500.00
Implementation Priority:	4	Facility Function:	
Implementation Phase:		Implementation Date:	
Official Responsible:

Notes: Two - way intersection corners B,C

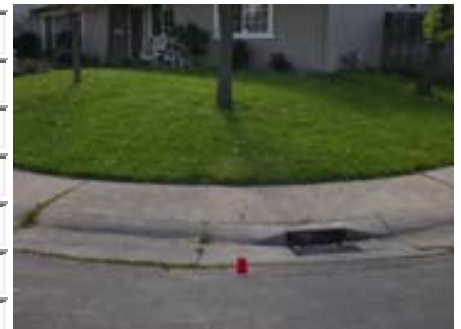
Field Date:	4/7/2011	Report Date:	4/8/2011	Barrier #:	6685
Location:	Camel Rock Wy and Escalante Wy - Corner C				
X Coordinate:	-121.26831				
Y Coordinate:	38.69724				
Barrier Area:	Curb Ramps				
Barrier Type:	No Curb Ramp				
Code Ref:	CBC 1127B.5.1 and ADA/ABA 402.2

As Built Meas:	1	Quantity:	EACH
Description:	No curb cut at corner (intersection)		
As Built Desc:	No curb ramp at corner		
Solution:	Demolish existing and construct curb cut		
Bar. Severity:	1 Necessary	Cost Estimate:	\$2,500.00
Implementation Priority:	4	Facility Function:	
Implementation Phase:		Implementation Date:	
Official Responsible:

Notes: Two - way intersection corners B,C

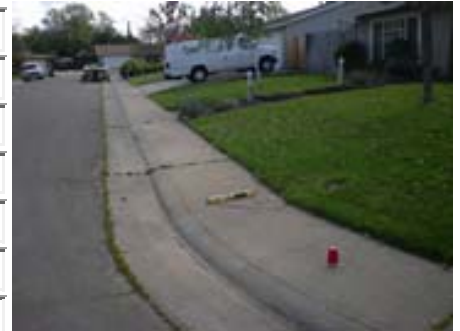
Field Date:	4/7/2011	Report Date:	4/8/2011	Barrier #:	6686
Location:	Escalante Wy - South				
X Coordinate:	-121.26805				
Y Coordinate:	38.69724				
Barrier Area:	Sidewalks				
Barrier Type:	Cross Slope - Existing (3.1% to 4.0%)				
Code Ref:	CBC 1133B.7.1.3 and ADA/ABA 403.3

As Built Meas:	218	Quantity:	LF
Description:	Cross slope exceeds 2.0% (3.1% to 4.0%)		
As Built Desc:	3.8% cross slope		
Solution:	Demolish existing and construct new route		
Bar. Severity:	3 Hindrance	Cost Estimate:	\$27,250.00
Implementation Priority:	4	Facility Function:	
Implementation Phase:		Implementation Date:	
Official Responsible:

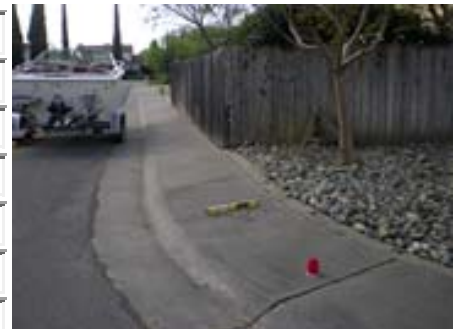
Field Date:	4/7/2011	Report Date:	4/8/2011	Barrier #:	6687
Location:	Escalante Wy - West				
X Coordinate:	-121.26747				
Y Coordinate:	38.69721				
Barrier Area:	Sidewalks				
Barrier Type:	Cross Slope - Existing (3.1% to 4.0%)				
Code Ref:	CBC 1133B.7.1.3 and ADA/ABA 403.3

As Built Meas:	284	Quantity:	LF
Description:	Cross slope exceeds 2.0% (3.1% to 4.0%)		
As Built Desc:	3.8% cross slope		
Solution:	Demolish existing and construct new route		
Bar. Severity:	3 Hindrance	Cost Estimate:	\$35,500.00
Implementation Priority:	4	Facility Function:	
Implementation Phase:		Implementation Date:	
Official Responsible:

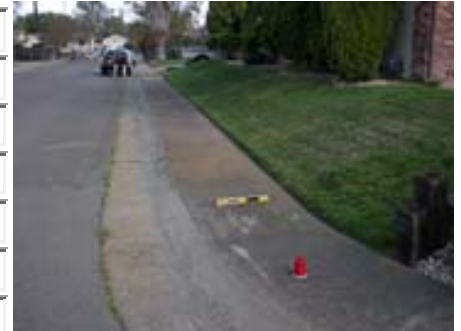
Barrier Type: Cross Slope - Existing (4.1% to 4.9%)

Code Ref: CBC 1133B.7.1.3 and ADA/ABA 403.3

As Built Meas: 316 Quantity: LF

Description: Cross slope exceeds 2.0% (4.1% to 4.9%)

Bar. Severity: 2 Recommended Cost Estimate: \$39,500.00 Status:

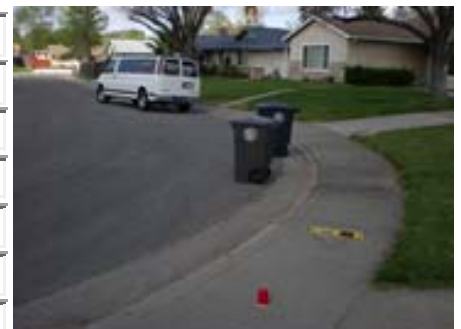
Barrier Type: Cross Slope - Existing (4.1% to 4.9%)

Code Ref: CBC 1133B.7.1.3 and ADA/ABA 403.3

As Built Meas: 276 Quantity: LF

Description: Cross slope exceeds 2.0% (4.1% to 4.9%)

Bar. Severity: 2 Recommended Cost Estimate: \$34,500.00 Status:

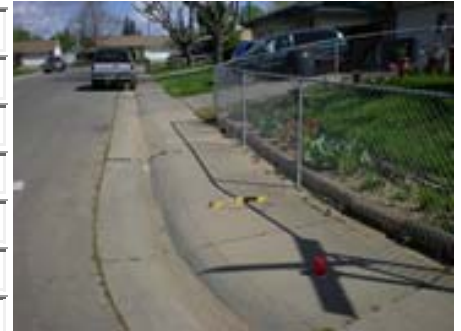
Field Date:	4/7/2011	Report Date:	4/8/2011	Barrier #:	6690
Location:	Camel Rock Wy - East				
X Coordinate:	-121.2683				
Y Coordinate:	38.69748				
Barrier Area:	Sidewalks				
Barrier Type:	Cross Slope - Existing (4.1% to 4.9%)				
Code Ref:	CBC 1133B.7.1.3 and ADA/ABA 403.3

As Built Meas:	207	Quantity:	LF
Description:	Cross slope exceeds 2.0% (4.1% to 4.9%)		
As Built Desc:	4.1% cross slope		
Solution:	Demolish existing and construct new route		
Bar. Severity:	2 Recommended	Cost Estimate:	\$25,875.00
Implementation Priority:	4	Facility Function:	
Implementation Phase:		Implementation Date:	
Official Responsible:			
Notes:

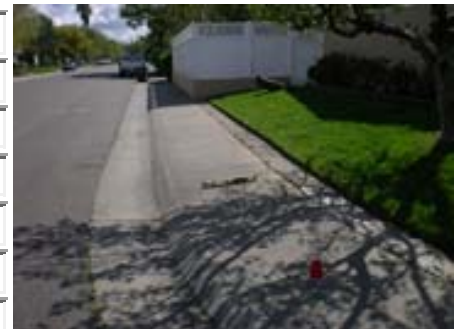
Field Date:	4/7/2011	Report Date:	4/8/2011	Barrier #:	6691
Location:	San Cosme Dr - South				
X Coordinate:	-121.26813				
Y Coordinate:	38.69802				
Barrier Area:	Sidewalks				
Barrier Type:	Cross Slope - Existing (5.0% or more)				
Code Ref:	CBC 1133B.7.1.3 and ADA/ABA 403.3

As Built Meas:	517	Quantity:	LF
Description:	Cross slope exceeds 2.0% (5.0% or more)		
As Built Desc:	5.0% cross slope		
Solution:	Demolish existing and construct new route		
Bar. Severity:	1 Necessary	Cost Estimate:	\$64,625.00
Implementation Priority:	4	Facility Function:	
Implementation Phase:		Implementation Date:	
Official Responsible:			
Notes:

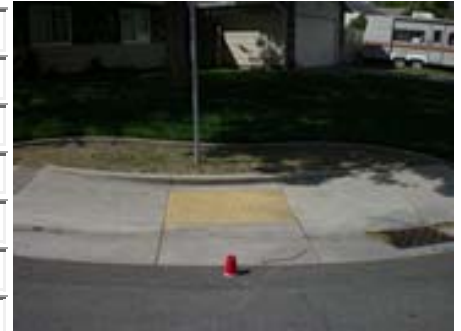
Field Date:	4/7/2011	Report Date:	4/8/2011	Barrier #:	6692
Location:	San Cosme Dr and Ocone Ct - Corner D				
X Coordinate:	-121.26645				
Y Coordinate:	38.69802				
Barrier Area:	Curb Ramps				
Barrier Type:	12" Grooves - Existing (2.1% to 3.0%)				
Code Ref:	CBC 1127B.5.6

As Built Meas:	1	Quantity:	EACH
Description:	12" grooves at top of curb ramp are not level (2.1% to 3.0%)		
As Built Desc:	3.0% at 12" grooves		
Solution:	Demolish existing and construct new curb ramp		
Bar. Severity:	4 Low Severity	Cost Estimate:	\$2,500.00
Implementation Priority:	4	Facility Function:	
Implementation Phase:		Implementation Date:	
Official Responsible:

Notes: Two - way intersection corners C, D. Corner C compliant

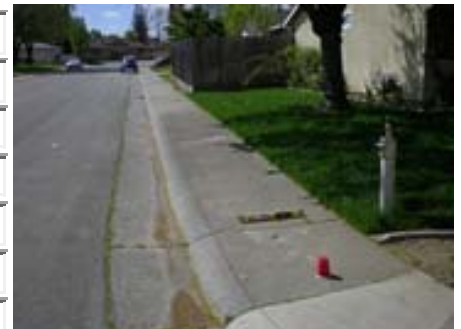
Field Date:	4/7/2011	Report Date:	4/8/2011	Barrier #:	6693
Location:	Ocone Ct - West				
X Coordinate:	-121.26642				
Y Coordinate:	38.69796				
Barrier Area:	Sidewalks				
Barrier Type:	Cross Slope - Existing (3.1% to 4.0%)				
Code Ref:	CBC 1133B.7.1.3 and ADA/ABA 403.3

As Built Meas:	361	Quantity:	LF
Description:	Cross slope exceeds 2.0% (3.1% to 4.0%)		
As Built Desc:	4.0% cross slope		
Solution:	Demolish existing and construct new route		
Bar. Severity:	3 Hindrance	Cost Estimate:	\$45,125.00
Implementation Priority:	4	Facility Function:	
Implementation Phase:		Implementation Date:	
Official Responsible:

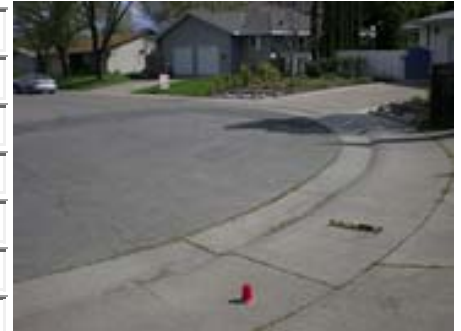
Field Date:	4/7/2011	Report Date:	4/8/2011	Barrier #:	6694
Location:	Ocone Ct - East				
X Coordinate:	-121.26629				
Y Coordinate:	38.69771				
Barrier Area:	Sidewalks				
Barrier Type:	Cross Slope - Existing (4.1% to 4.9%)				
Code Ref:	CBC 1133B.7.1.3 and ADA/ABA 403.3

As Built Meas:	366	Quantity:	LF
Description:	Cross slope exceeds 2.0% (4.1% to 4.9%)		
As Built Desc:	4.7% cross slope		
Solution:	Demolish existing and construct new route		
Bar. Severity:	2 Recommended	Cost Estimate:	\$45,750.00
Implementation Priority:	4	Facility Function:	
Implementation Phase:		Implementation Date:	
Official Responsible:

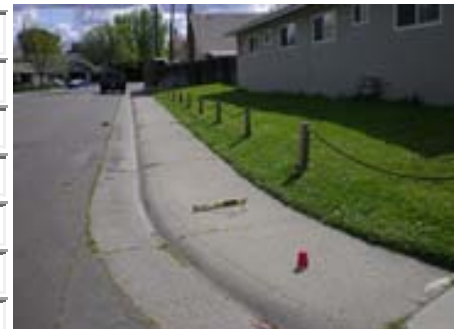
Field Date:	4/7/2011	Report Date:	4/8/2011	Barrier #:	6695
Location:	San Cosme Dr - South				
X Coordinate:	-121.26612				
Y Coordinate:	38.69803				
Barrier Area:	Sidewalks				
Barrier Type:	Cross Slope - Existing (3.1% to 4.0%)				
Code Ref:	CBC 1133B.7.1.3 and ADA/ABA 403.3

As Built Meas:	200	Quantity:	LF
Description:	Cross slope exceeds 2.0% (3.1% to 4.0%)		
As Built Desc:	3.8% cross slope		
Solution:	Demolish existing and construct new route		
Bar. Severity:	3 Hindrance	Cost Estimate:	\$25,000.00
Implementation Priority:	4	Facility Function:	
Implementation Phase:		Implementation Date:	
Official Responsible:

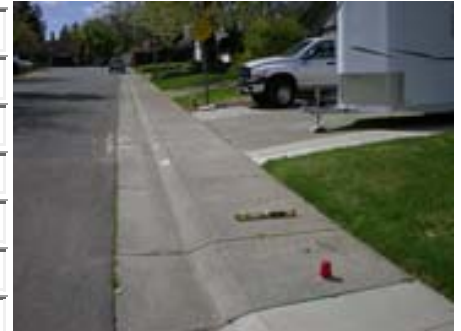
Field Date:	4/7/2011	Report Date:	4/8/2011	Barrier #:	6696A
Location:	Alma Mesa Wy - West				
X Coordinate:	-121.26552				
Y Coordinate:	38.69776				
Barrier Area:	Sidewalks				
Barrier Type:	Cross Slope - Existing (4.1% to 4.9%)				
Code Ref:	CBC 1133B.7.1.3 and ADA/ABA 403.3

As Built Meas:	371	Quantity:	LF
Description:	Cross slope exceeds 2.0% (4.1% to 4.9%)		
As Built Desc:	4.3% cross slope		
Solution:	Demolish existing and construct new route		
Bar. Severity:	2 Recommended	Cost Estimate:	\$46,375.00
Implementation Priority:	4	Facility Function:	
Implementation Phase:		Implementation Date:	
Official Responsible:			
Notes:

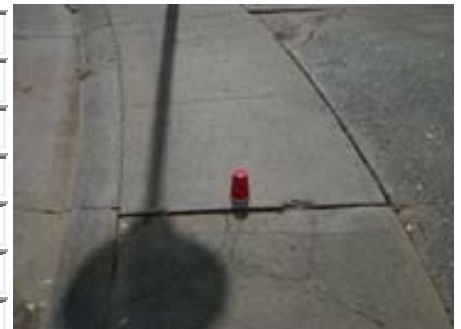
Field Date:	4/7/2011	Report Date:	4/8/2011	Barrier #:	6696B
Location:	Alma Mesa Wy - West				
X Coordinate:	-121.26549				
Y Coordinate:	38.69706				
Barrier Area:	Sidewalks				
Barrier Type:	Abrupt Change in Level - > 1/2"				
Code Ref:	CBC 1133B.7.1 and ADA/ABA 303.3

As Built Meas:	4	Quantity:	LF
Description:	Change in level greater than 1/2"		
As Built Desc:	1/2" lip in sidewalk surface		
Solution:	Grind or repair sidewalk to remove trip hazard		
Bar. Severity:	1 Necessary	Cost Estimate:	\$1,000.00
Implementation Priority:	4	Facility Function:	
Implementation Phase:		Implementation Date:	
Official Responsible:			
Notes:

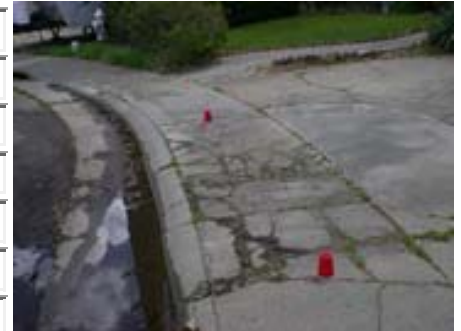
Field Date:	4/7/2011	Report Date:	4/8/2011	Barrier #:	6697
Location:	Alma Mesa Wy - East				
X Coordinate:	-121.2653				
Y Coordinate:	38.69703				
Barrier Area:	Sidewalks				
Barrier Type:	Surface Condition - Damaged				
Code Ref:	CBC 1133B.7.1 and ADA/ABA 302.1

As Built Meas:	8	Quantity:	LF
Description:	Surface is not firm and stable (cracked, broken or loose soil, etc.)		
As Built Desc:	Cracked concrete		
Solution:	Repair surface to make firm and stable		
Bar. Severity:	1 Necessary	Cost Estimate:	\$1,000.00
Implementation Priority:	4	Facility Function:	
Implementation Phase:		Implementation Date:	
Official Responsible:			
Notes:

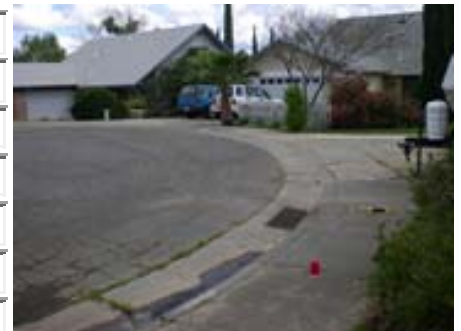
Field Date:	4/7/2011	Report Date:	4/8/2011	Barrier #:	6698
Location:	Alma Mesa Wy - East				
X Coordinate:	-121.26531				
Y Coordinate:	38.69716				
Barrier Area:	Sidewalks				
Barrier Type:	Cross Slope - Existing (4.1% to 4.9%)				
Code Ref:	CBC 1133B.7.1.3 and ADA/ABA 403.3

As Built Meas:	409	Quantity:	LF
Description:	Cross slope exceeds 2.0% (4.1% to 4.9%)		
As Built Desc:	4.9% cross slope		
Solution:	Demolish existing and construct new route		
Bar. Severity:	2 Recommended	Cost Estimate:	\$51,125.00
Implementation Priority:	4	Facility Function:	
Implementation Phase:		Implementation Date:	
Official Responsible:			
Notes:

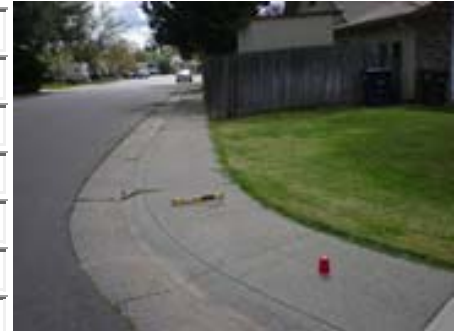
Field Date:	4/7/2011	Report Date:	4/8/2011	Barrier #:	6699
Location:	San Cosme Dr - South				
X Coordinate:	-121.26534				
Y Coordinate:	38.69801				
Barrier Area:	Sidewalks				
Barrier Type:	Cross Slope - Existing (3.1% to 4.0%)				
Code Ref:	CBC 1133B.7.1.3 and ADA/ABA 403.3

As Built Meas:	335	Quantity:	LF
Description:	Cross slope exceeds 2.0% (3.1% to 4.0%)		
As Built Desc:	4.0% cross slope		
Solution:	Demolish existing and construct new route		
Bar. Severity:	3 Hindrance	Cost Estimate:	\$41,875.00
Implementation Priority:	4	Facility Function:	
Implementation Phase:		Implementation Date:	
Official Responsible:

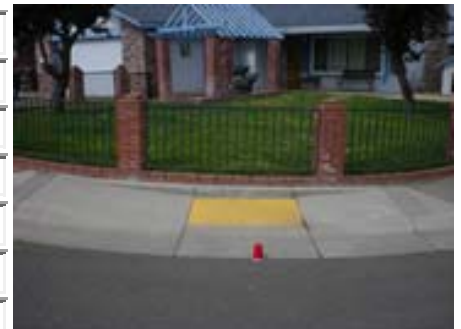
Field Date:	4/7/2011	Report Date:	4/8/2011	Barrier #:	6700
Location:	San Cosme Dr and San Cosme Ct - Corner D				
X Coordinate:	-121.26441				
Y Coordinate:	38.69737				
Barrier Area:	Curb Ramps				
Barrier Type:	12" Grooves - Existing (3.1% to 4.0%)				
Code Ref:	CBC 1127B.5.6

As Built Meas:	1	Quantity:	EACH
Description:	12" grooves at top of curb ramp are not level (3.1% to 4.0%)		
As Built Desc:	3.7% at 12" grooves		
Solution:	Demolish existing and construct new curb ramp		
Bar. Severity:	3 Hindrance	Cost Estimate:	\$2,500.00
Implementation Priority:	4	Facility Function:	
Implementation Phase:		Implementation Date:	
Official Responsible:

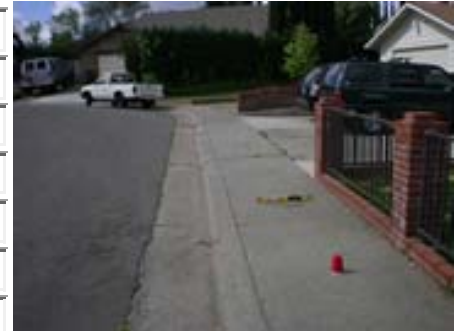
Field Date:	4/7/2011	Report Date:	4/8/2011	Barrier #:	6701
Location:	San Cosme Ct - West				
X Coordinate:	-121.26447				
Y Coordinate:	38.69732				
Barrier Area:	Sidewalks				
Barrier Type:	Cross Slope - Existing (4.1% to 4.9%)				
Code Ref:	CBC 1133B.7.1.3 and ADA/ABA 403.3

As Built Meas:	130	Quantity:	LF
Description:	Cross slope exceeds 2.0% (4.1% to 4.9%)		
As Built Desc:	4.3% cross slope		
Solution:	Demolish existing and construct new route		
Bar. Severity:	2 Recommended	Cost Estimate:	\$16,250.00
Implementation Priority:	4	Facility Function:	
Implementation Phase:		Implementation Date:	
Official Responsible:

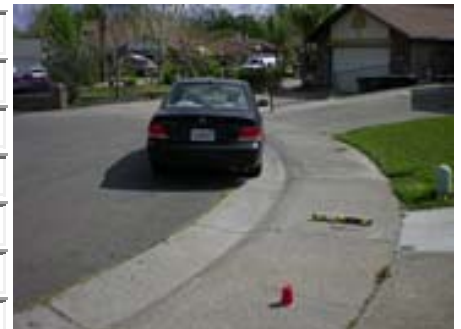
Field Date:	4/7/2011	Report Date:	4/8/2011	Barrier #:	6702
Location:	San Cosme Ct - East				
X Coordinate:	-121.26449				
Y Coordinate:	38.69704				
Barrier Area:	Sidewalks				
Barrier Type:	Cross Slope - Existing (4.1% to 4.9%)				
Code Ref:	CBC 1133B.7.1.3 and ADA/ABA 403.3

As Built Meas:	103	Quantity:	LF
Description:	Cross slope exceeds 2.0% (4.1% to 4.9%)		
As Built Desc:	4.1% cross slope		
Solution:	Demolish existing and construct new route		
Bar. Severity:	2 Recommended	Cost Estimate:	\$12,875.00
Implementation Priority:	4	Facility Function:	
Implementation Phase:		Implementation Date:	
Official Responsible:

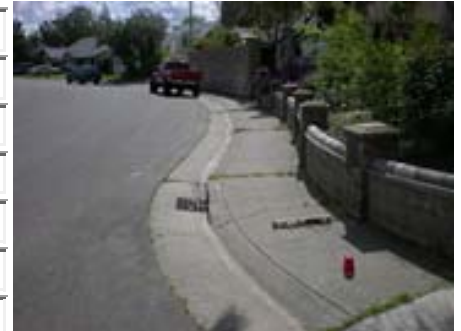
Field Date:	4/7/2011	Report Date:	4/8/2011	Barrier #:	6703
Location:	San Cosme Dr - South				
X Coordinate:	-121.26385				
Y Coordinate:	38.69716				
Barrier Area:	Sidewalks				
Barrier Type:	Cross Slope - Existing (3.1% to 4.0%)				
Code Ref:	CBC 1133B.7.1.3 and ADA/ABA 403.3

As Built Meas:	450	Quantity:	LF
Description:	Cross slope exceeds 2.0% (3.1% to 4.0%)		
As Built Desc:	4.0% cross slope		
Solution:	Demolish existing and construct new route		
Bar. Severity:	3 Hindrance	Cost Estimate:	\$56,250.00
Implementation Priority:	4	Facility Function:	
Implementation Phase:		Implementation Date:	
Official Responsible:

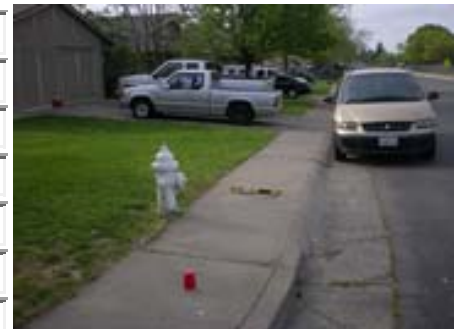
Field Date:	4/11/2011	Report Date:	4/11/2011	Barrier #:	6704
Location:	Canelo Hills Dr - East				
X Coordinate:	-121.26914				
Y Coordinate:	38.70002				
Barrier Area:	Sidewalks				
Barrier Type:	Cross Slope - Existing (5.0% or more)				
Code Ref:	CBC 1133B.7.1.3 and ADA/ABA 403.3

As Built Meas:	478	Quantity:	LF
Description:	Cross slope exceeds 2.0% (5.0% or more)		
As Built Desc:	5.7% cross slope		
Solution:	Demolish existing and construct new route		
Bar. Severity:	1 Necessary	Cost Estimate:	\$59,750.00
Implementation Priority:	3	Facility Function:	
Implementation Phase:		Implementation Date:	
Official Responsible:

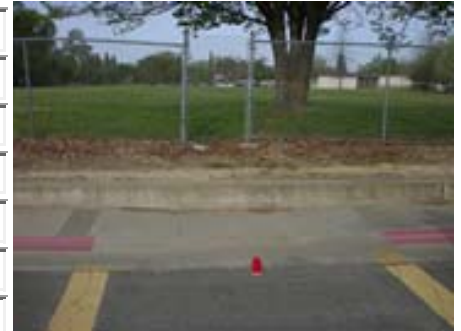
Field Date:	4/11/2011	Report Date:	4/11/2011	Barrier #:	6705A
Location:	Canelo Hills Dr and Dana Butte Wy - Corner A				
X Coordinate:	-121.26951				
Y Coordinate:	38.69888				
Barrier Area:	Curb Ramps				
Barrier Type:	12" Grooves - Existing (3.1% to 4.0%)				
Code Ref:	CBC 1127B.5.6

As Built Meas:	1	Quantity:	EACH
Description:	12" grooves at top of curb ramp are not level (3.1% to 4.0%)		
As Built Desc:	3.4% at 12" grooves		
Solution:	Demolish existing and construct new curb ramp		
Bar. Severity:	3 Hindrance	Cost Estimate:	\$2,500.00
Implementation Priority:	3	Facility Function:	
Implementation Phase:		Implementation Date:	
Official Responsible:

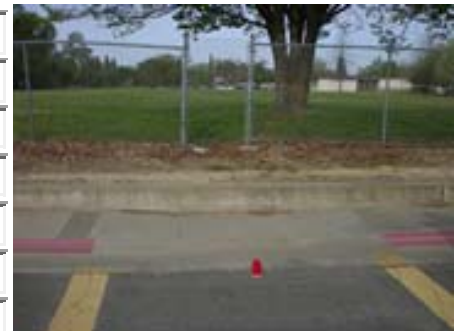
As Built Meas:	1	Quantity:	EACH
Description:	Ramp run cross slope exceeds 2.0% (9.0% to 9.4%)		
As Built Desc:	9.0% running slope		
Solution:	Demolish existing and construct new curb ramp		
Bar. Severity:	2 Recommended	Cost Estimate:	\$0.00
Implementation Priority:	3	Facility Function:	
Implementation Phase:		Implementation Date:	
Official Responsible:

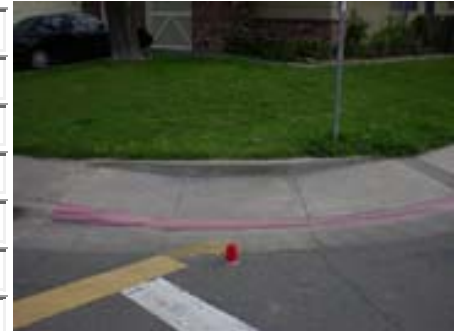
Field Date:	4/11/2011	Report Date:	4/11/2011	Barrier #:	6706A
Location:	Canelo Hills Dr and Dana Butte Wy - Corner B				
X Coordinate:	-121.26918				
Y Coordinate:	38.69892				
Barrier Area:	Curb Ramps				
Barrier Type:	12" Grooves - Existing (4.1% to 4.9%)				
Code Ref:	CBC 1127B.5.6

As Built Meas:	1	Quantity:	EACH
Description:	12" grooves at top of curb ramp are not level (4.1% to 4.9%)		
As Built Desc:	4.9% at 12" grooves		
Solution:	Demolish existing and construct new curb ramp		
Bar. Severity:	2 Recommended	Cost Estimate:	\$2,500.00
Implementation Priority:	3	Facility Function:	
Implementation Phase:		Implementation Date:	
Official Responsible:			
Notes:	Three - way intersection corners A, B, C
