DRAFT ADA TRANSITION PLAN UPDATE
NEIGHBORHOOD AREA 9 SONA
SEPTEMBER 20, 2011

CITY OF CITRUS HEIGHTS

The Sunrise Oaks Neighborhood Association (SONA)

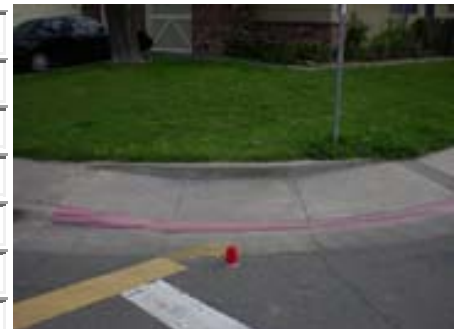
As Built Meas:	1	Quantity:	EACH
Description:	Ramp run cross slope exceeds 2.0% (3.1% to 4.0%)		
As Built Desc:	3.2% cross slope		
Solution:	Demolish existing and construct new curb ramp		
Bar. Severity:	3 Hindrance	Cost Estimate:	\$0.00
Implementation Priority:	3	Facility Function:	
Implementation Phase:		Implementation Date:	
Official Responsible:			
Notes:	Three - way intersection corners A, B, C

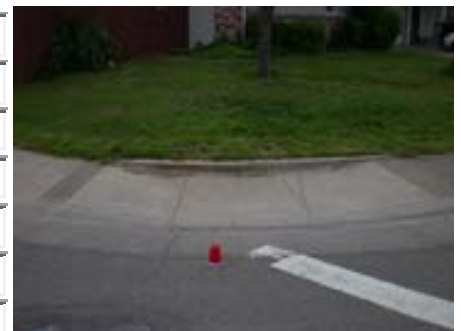
Barrier Type: 12" Grooves - Existing (>5.0%)

Description: 12" grooves at top of curb ramp are not level (>5.0%)

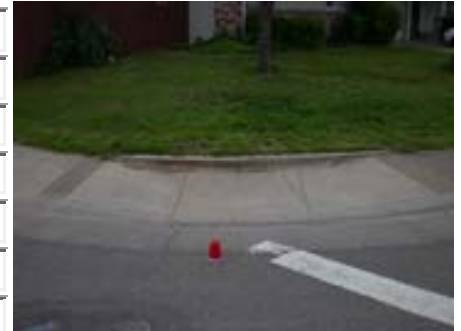
As Built Meas:	1	Quantity:	EACH
Description:	Ramp run cross slope exceeds 2.0% (3.1% to 4.0%)		
As Built Desc:	3.9% cross slope		
Solution:	Demolish existing and construct new curb ramp		
Bar. Severity:	3 Hindrance	Cost Estimate:	\$0.00
Implementation Priority:	3	Facility Function:	
Implementation Phase:		Implementation Date:	
Official Responsible:

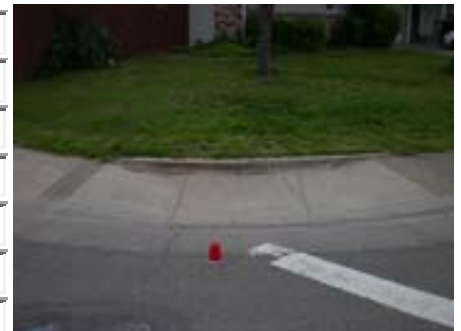
As Built Meas:	1	Quantity:	EACH
Description:	No truncated domes provided at curb ramp		
As Built Desc:	No detectable warnings at curb ramp		
Solution:	Provide compliant truncated domes		
Bar. Severity:	2 Recommended	Cost Estimate:	\$0.00
Implementation Priority:	3	Facility Function:	
Implementation Phase:		Implementation Date:	
Official Responsible:

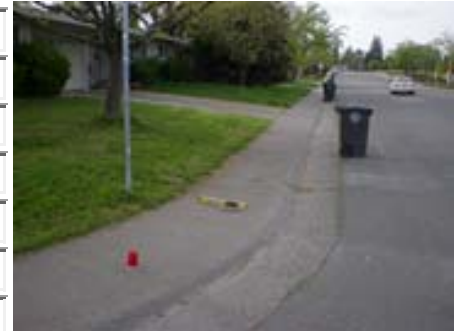
Barrier Type: Cross Slope - Existing (4.1% to 4.9%)

Description: Cross slope exceeds 2.0% (4.1% to 4.9%)

Bar. Severity: 2 Recommended Cost Estimate: \$26,875.00 Status:

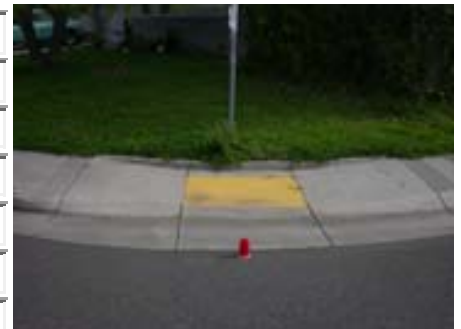
Barrier Type: 12" Grooves - Existing (3.1% to 4.0%)

Description: 12" grooves at top of curb ramp are not level (3.1% to 4.0%)

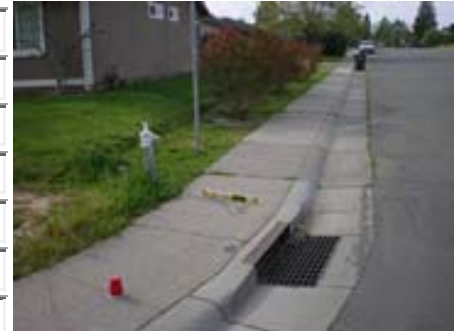
Field Date:	4/11/2011	Report Date:	4/11/2011	Barrier #:	6710
Location:	Canelo Hills Dr - East				
X Coordinate:	-121.26913				
Y Coordinate:	38.69769				
Barrier Area:	Sidewalks				
Barrier Type:	Cross Slope - Existing (4.1% to 4.9%)				
Code Ref:	CBC 1133B.7.1.3 and ADA/ABA 403.3

As Built Meas:	558	Quantity:	LF
Description:	Cross slope exceeds 2.0% (4.1% to 4.9%)		
As Built Desc:	4.4% cross slope		
Solution:	Demolish existing and construct new route		
Bar. Severity:	2 Recommended	Cost Estimate:	\$69,750.00
Implementation Priority:	3	Facility Function:	
Implementation Phase:		Implementation Date:	
Official Responsible:

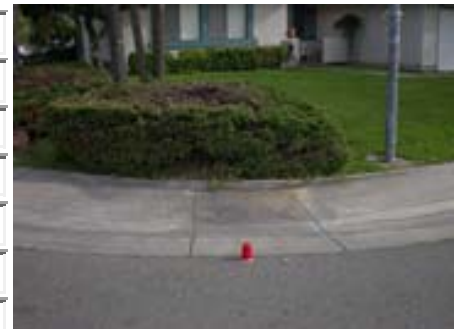
Field Date:	4/11/2011	Report Date:	4/11/2011	Barrier #:	6711A
Location:	Canelo Hills Dr and Copperwood Dr - Corner B				
X Coordinate:	-121.26911				
Y Coordinate:	38.69644				
Barrier Area:	Curb Ramps				
Barrier Type:	12" Grooves - Existing (3.1% to 4.0%)				
Code Ref:	CBC 1127B.5.6

As Built Meas:	1	Quantity:	EACH
Description:	12" grooves at top of curb ramp are not level (3.1% to 4.0%)		
As Built Desc:	3.7% at 12" grooves		
Solution:	Demolish existing and construct new curb ramp		
Bar. Severity:	3 Hindrance	Cost Estimate:	\$2,500.00
Implementation Priority:	3	Facility Function:	
Implementation Phase:		Implementation Date:	
Official Responsible:

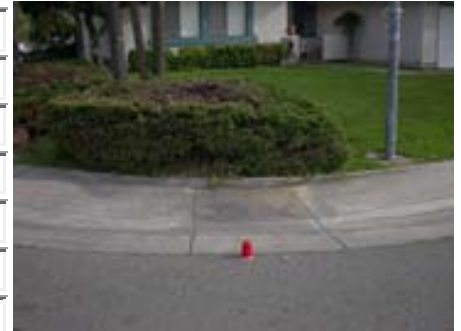
As Built Meas:	1	Quantity:	EACH
Description:	No truncated domes provided at curb ramp		
As Built Desc:	No detectable warnings at curb ramp		
Solution:	Provide compliant truncated domes		
Bar. Severity:	2 Recommended	Cost Estimate:	\$0.00
Implementation Priority:	3	Facility Function:	
Implementation Phase:		Implementation Date:	
Official Responsible:

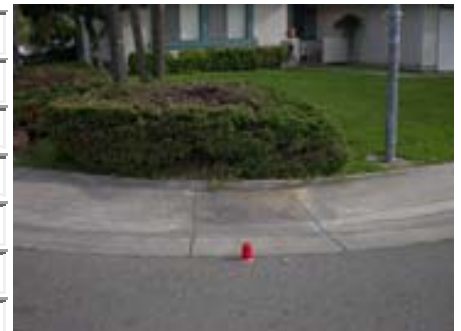
As Built Meas:	6	Quantity:	SF
Description:	Gutter slope exceeds 5.0% (8.3% or more)		
As Built Desc:	14.3% gutter slope		
Solution:	Demolish existing and construct new gutter		
Bar. Severity:	1 Necessary	Cost Estimate:	\$0.00
Implementation Priority:	3	Facility Function:	
Implementation Phase:		Implementation Date:	
Official Responsible:

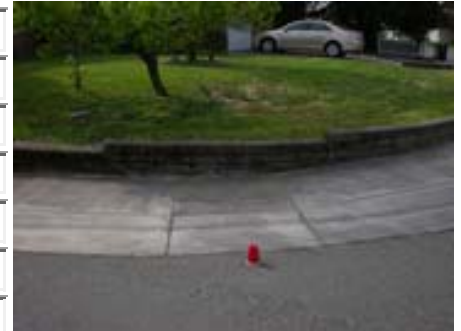
Field Date:	4/11/2011	Report Date:	4/11/2011	Barrier #:	6712A
Location:	Canelo Hills Dr and Copperwood Dr - Corner C				
X Coordinate:	-121.26913				
Y Coordinate:	38.69627				
Barrier Area:	Curb Ramps				
Barrier Type:	12" Grooves - Existing (3.1% to 4.0%)				
Code Ref:	CBC 1127B.5.6

As Built Meas:	1	Quantity:	EACH
Description:	12" grooves at top of curb ramp are not level (3.1% to 4.0%)		
As Built Desc:	3.1% at 12" grooves		
Solution:	Demolish existing and construct new curb ramp		
Bar. Severity:	3 Hindrance	Cost Estimate:	\$2,500.00
Implementation Priority:	3	Facility Function:	
Implementation Phase:		Implementation Date:	
Official Responsible:

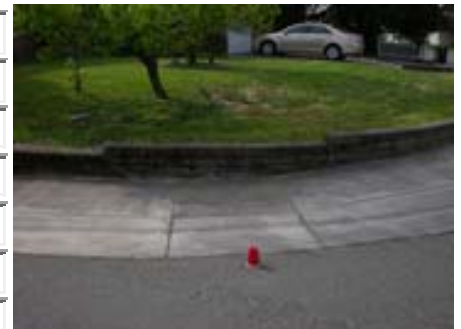
As Built Meas:	1	Quantity:	EACH
Description:	No truncated domes provided at curb ramp		
As Built Desc:	No detectable warnings at curb ramp		
Solution:	Provide compliant truncated domes		
Bar. Severity:	2 Recommended	Cost Estimate:	\$0.00
Implementation Priority:	3	Facility Function:	
Implementation Phase:		Implementation Date:	
Official Responsible:

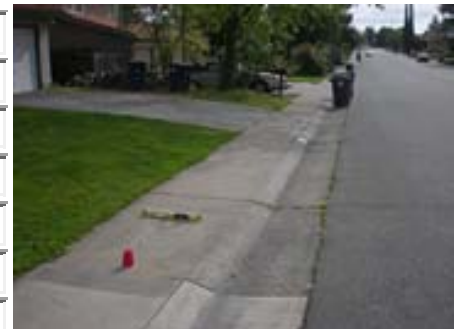
Field Date:	4/11/2011	Report Date:	4/11/2011	Barrier #:	6713
Location:	Copperwood Dr - North				
X Coordinate:	-121.26885				
Y Coordinate:	38.69644				
Barrier Area:	Sidewalks				
Barrier Type:	Cross Slope - Existing (4.1% to 4.9%)				
Code Ref:	CBC 1133B.7.1.3 and ADA/ABA 403.3

As Built Meas:	192	Quantity:	LF
Description:	Cross slope exceeds 2.0% (4.1% to 4.9%)		
As Built Desc:	4.5% cross slope		
Solution:	Demolish existing and construct new route		
Bar. Severity:	2 Recommended	Cost Estimate:	\$24,000.00
Implementation Priority:	4	Facility Function:	
Implementation Phase:		Implementation Date:	
Official Responsible:

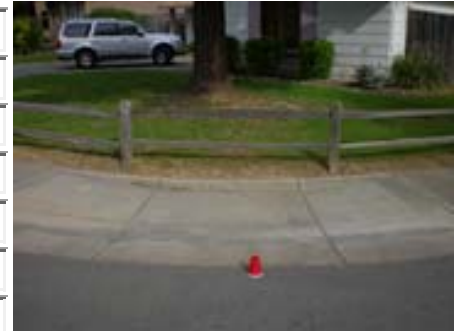
Field Date:	4/11/2011	Report Date:	4/11/2011	Barrier #:	6714A
Location:	Copperwood Dr and Camel Rock Wy - Corner A				
X Coordinate:	-121.26848				
Y Coordinate:	38.69644				
Barrier Area:	Curb Ramps				
Barrier Type:	12" Grooves - Existing (>5.0%)				
Code Ref:	CBC 1127B.5.6

As Built Meas:	1	Quantity:	EACH
Description:	12" grooves at top of curb ramp are not level (>5.0%)		
As Built Desc:	6.6% at 12" grooves		
Solution:	Demolish existing and construct new curb ramp		
Bar. Severity:	1 Necessary	Cost Estimate:	\$2,500.00
Implementation Priority:	4	Facility Function:	
Implementation Phase:		Implementation Date:	
Official Responsible:

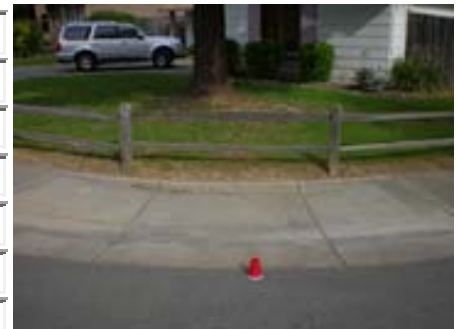
Field Date:	4/11/2011	Report Date:	4/11/2011	Barrier #:	6714B
Location:	Copperwood Dr and Camel Rock Wy - Corner A				
X Coordinate:	-121.26848				
Y Coordinate:	38.69644				
Barrier Area:	Curb Ramps				
Barrier Type:	Cross Slope - Existing (2.1% to 3.0%)				
Code Ref:	CBC 1127B.5.3 and ADA/ABA 406.2

As Built Meas:	1	Quantity:	EACH
Description:	Ramp run cross slope exceeds 2.0% (2.1% to 3.0%)		
As Built Desc:	2.9% cross slope		
Solution:	Demolish existing and construct new curb ramp		
Bar. Severity:	4 Low Severity	Cost Estimate:	\$0.00
Implementation Priority:	4	Facility Function:	
Implementation Phase:		Implementation Date:	
Official Responsible:

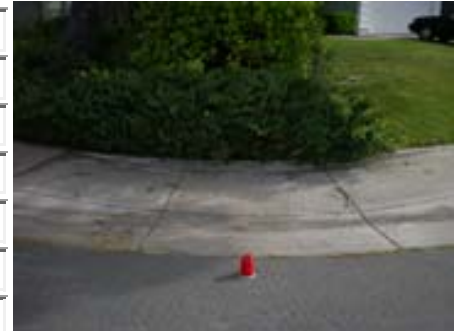
Field Date:	4/11/2011	Report Date:	4/11/2011	Barrier #:	6715A
Location:	Copperwood Dr and Camel Rock Wy - Corner B				
X Coordinate:	-121.26826				
Y Coordinate:	38.69642				
Barrier Area:	Curb Ramps				
Barrier Type:	12" Grooves - Existing (3.1% to 4.0%)				
Code Ref:	CBC 1127B.5.6

As Built Meas:	1	Quantity:	EACH
Description:	12" grooves at top of curb ramp are not level (3.1% to 4.0%)		
As Built Desc:	3.7% at 12" grooves		
Solution:	Demolish existing and construct new curb ramp		
Bar. Severity:	3 Hindrance	Cost Estimate:	\$2,500.00
Implementation Priority:	4	Facility Function:	
Implementation Phase:		Implementation Date:	
Official Responsible:			
Notes:	Four - way intersection corners A, B, C, D

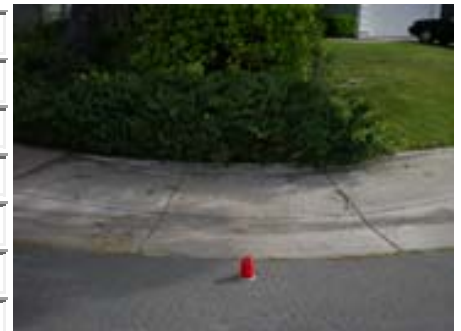
Field Date:	4/11/2011	Report Date:	4/11/2011	Barrier #:	6715B
Location:	Copperwood Dr and Camel Rock Wy - Corner B				
X Coordinate:	-121.26826				
Y Coordinate:	38.69642				
Barrier Area:	Curb Ramps				
Barrier Type:	Cross Slope - Existing (3.1% to 4.0%)				
Code Ref:	CBC 1127B.5.3 and ADA/ABA 406.2

As Built Meas:	1	Quantity:	EACH
Description:	Ramp run cross slope exceeds 2.0% (3.1% to 4.0%)		
As Built Desc:	3.8% cross slope		
Solution:	Demolish existing and construct new curb ramp		
Bar. Severity:	3 Hindrance	Cost Estimate:	\$0.00
Implementation Priority:	4	Facility Function:	
Implementation Phase:		Implementation Date:	
Official Responsible:			
Notes:	Four - way intersection corners A, B, C, D

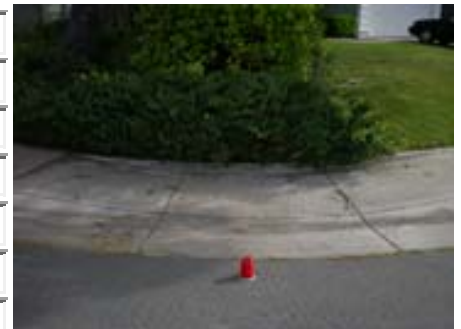
Field Date:	4/11/2011	Report Date:	4/11/2011	Barrier #:	6715D
Location:	Copperwood Dr and Camel Rock Wy - Corner B				
X Coordinate:	-121.26826				
Y Coordinate:	38.69642				
Barrier Area:	Curb Ramps				
Barrier Type:	Detectable Warnings - Truncated Domes				
Code Ref:	CBC 1127B.5.7 and ADA/ABA 705.1.3

As Built Meas:	1	Quantity:	EACH
Description:	No truncated domes provided at curb ramp		
As Built Desc:	No detectable warnings at curb ramp		
Solution:	Provide compliant truncated domes		
Bar. Severity:	2 Recommended	Cost Estimate:	\$0.00
Implementation Priority:	4	Facility Function:	
Implementation Phase:		Implementation Date:	
Official Responsible:			
Notes:	Four - way intersection corners A, B, C, D

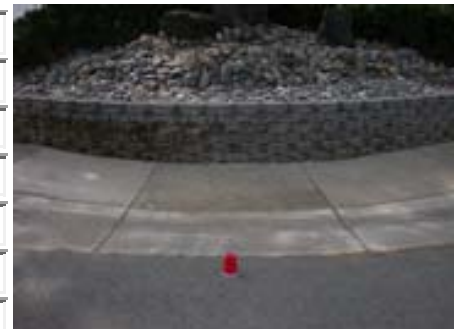
Field Date:	4/11/2011	Report Date:	4/11/2011	Barrier #:	6716A
Location:	Copperwood Dr and Camel Rock Wy - Corner C				
X Coordinate:	-121.26823				
Y Coordinate:	38.69632				
Barrier Area:	Curb Ramps				
Barrier Type:	12" Grooves - Existing (3.1% to 4.0%)				
Code Ref:	CBC 1127B.5.6

As Built Meas:	1	Quantity:	EACH
Description:	12" grooves at top of curb ramp are not level (3.1% to 4.0%)		
As Built Desc:	3.1% at 12" grooves		
Solution:	Demolish existing and construct new curb ramp		
Bar. Severity:	3 Hindrance	Cost Estimate:	\$0.00
Implementation Priority:	4	Facility Function:	
Implementation Phase:		Implementation Date:	
Official Responsible:			
Notes:	Four - way intersection corners A, B, C, D

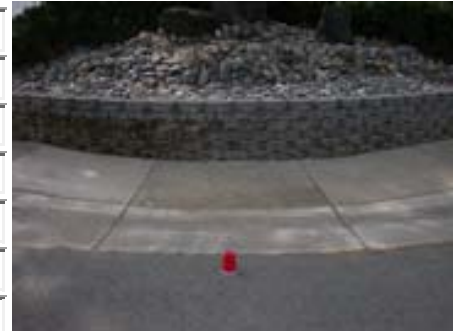
Field Date:	4/11/2011	Report Date:	4/11/2011	Barrier #:	6716B
Location:	Copperwood Dr and Camel Rock Wy - Corner C				
X Coordinate:	-121.26823				
Y Coordinate:	38.69632				
Barrier Area:	Curb Ramps				
Barrier Type:	Detectable Warnings - Truncated Domes				
Code Ref:	CBC 1127B.5.7 and ADA/ABA 705.1.3

As Built Meas:	1	Quantity:	EACH
Description:	No truncated domes provided at curb ramp		
As Built Desc:	No detectable warnings at curb ramp		
Solution:	Provide compliant truncated domes		
Bar. Severity:	2 Recommended	Cost Estimate:	\$0.00
Implementation Priority:	4	Facility Function:	
Implementation Phase:		Implementation Date:	
Official Responsible:			
Notes:	Four - way intersection corners A, B, C, D

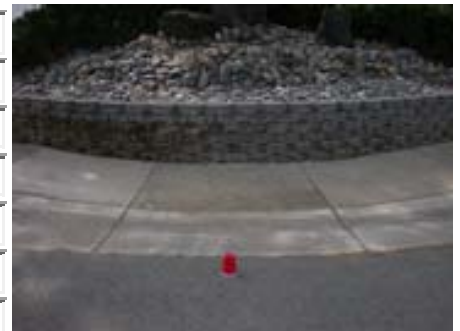
Field Date:	4/11/2011	Report Date:	4/11/2011	Barrier #:	6716C
Location:	Copperwood Dr and Camel Rock Wy - Corner C				
X Coordinate:	-121.26823				
Y Coordinate:	38.69632				
Barrier Area:	Curb Ramps				
Barrier Type:	Gutter Slope - Existing (8.3% or more)				
Code Ref:	CBC 1127B.5.3 and ADA/ABA 406.2

As Built Meas:	6	Quantity:	SF
Description:	Gutter slope exceeds 5.0% (8.3% or more)		
As Built Desc:	9.5% gutter slope		
Solution:	Demolish existing and construct new gutter		
Bar. Severity:	1 Necessary	Cost Estimate:	\$0.00
Implementation Priority:	4	Facility Function:	
Implementation Phase:		Implementation Date:	
Official Responsible:			
Notes:	Four - way intersection corners A, B, C, D

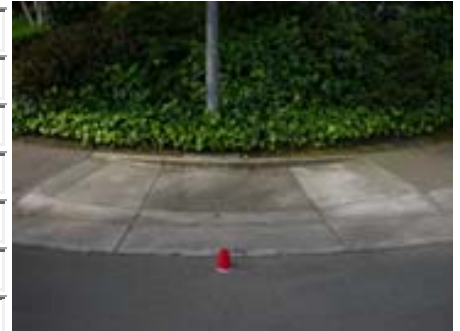
Field Date:	4/11/2011	Report Date:	4/11/2011	Barrier #:	6717A
Location:	Copperwood Dr and Camel Rock Wy - Corner D				
X Coordinate:	-121.26846				
Y Coordinate:	38.69632				
Barrier Area:	Curb Ramps				
Barrier Type:	12" Grooves - Existing (>5.0%)				
Code Ref:	CBC 1127B.5.6

As Built Meas:	1	Quantity:	EACH
Description:	12" grooves at top of curb ramp are not level (>5.0%)		
As Built Desc:	6.9% at 12" grooves		
Solution:	Demolish existing and construct new curb ramp		
Bar. Severity:	1 Necessary	Cost Estimate:	\$2,500.00
Implementation Priority:	4	Facility Function:	
Implementation Phase:		Implementation Date:	
Official Responsible:			
Notes:	Four - way intersection corners A, B, C, D

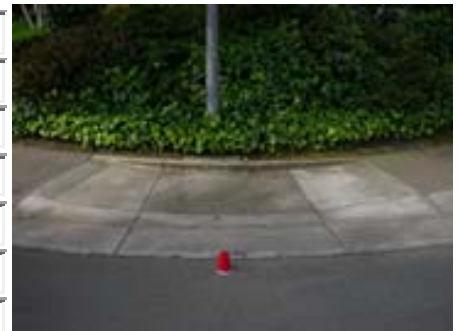
Field Date:	4/11/2011	Report Date:	4/11/2011	Barrier #:	6717B
Location:	Copperwood Dr and Camel Rock Wy - Corner D				
X Coordinate:	-121.26846				
Y Coordinate:	38.69632				
Barrier Area:	Curb Ramps				
Barrier Type:	Parallel Ramp Landing - Existing (3.1% to 4.0%)				
Code Ref:	CBC 1127B.5.4 and ADA/ABA 406.4

As Built Meas:	1	Quantity:	EACH
Description:	Curb ramp landing or pan not level (3.1% to 4.0%)		
As Built Desc:	3.1% landing slope		
Solution:	Demolish existing and construct new transition		
Bar. Severity:	3 Hindrance	Cost Estimate:	\$0.00
Implementation Priority:	4	Facility Function:	
Implementation Phase:		Implementation Date:	
Official Responsible:			
Notes:	Four - way intersection corners A, B, C, D

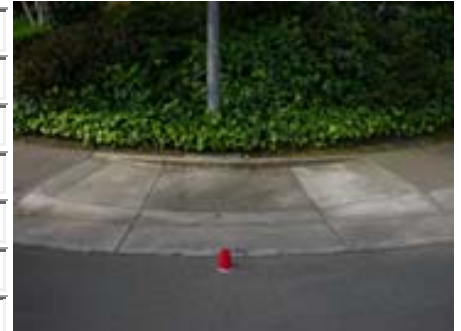
Field Date:	4/11/2011	Report Date:	4/11/2011	Barrier #:	6717C
Location:	Copperwood Dr and Camel Rock Wy - Corner D				
X Coordinate:	-121.26846				
Y Coordinate:	38.69632				
Barrier Area:	Curb Ramps				
Barrier Type:	Detectable Warnings - Truncated Domes				
Code Ref:	CBC 1127B.5.7 and ADA/ABA 705.1.3

As Built Meas:	1	Quantity:	EACH
Description:	No truncated domes provided at curb ramp		
As Built Desc:	No detectable warnings at curb ramp		
Solution:	Provide compliant truncated domes		
Bar. Severity:	2 Recommended	Cost Estimate:	\$0.00
Implementation Priority:	4	Facility Function:	
Implementation Phase:		Implementation Date:	
Official Responsible:			
Notes:	Four - way intersection corners A, B, C, D

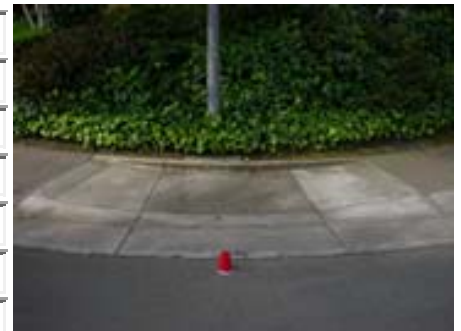
Field Date:	4/11/2011	Report Date:	4/11/2011	Barrier #:	6717D
Location:	Copperwood Dr and Camel Rock Wy - Corner D				
X Coordinate:	-121.26846				
Y Coordinate:	38.69632				
Barrier Area:	Curb Ramps				
Barrier Type:	Gutter Slope - Existing (8.3% or more)				
Code Ref:	CBC 1127B.5.3 and ADA/ABA 406.2

As Built Meas:	6	Quantity:	SF
Description:	Gutter slope exceeds 5.0% (8.3% or more)		
As Built Desc:	9.0% gutter slope		
Solution:	Demolish existing and construct new gutter		
Bar. Severity:	1 Necessary	Cost Estimate:	\$0.00
Implementation Priority:	4	Facility Function:	
Implementation Phase:		Implementation Date:	
Official Responsible:			
Notes:	Four - way intersection corners A, B, C, D

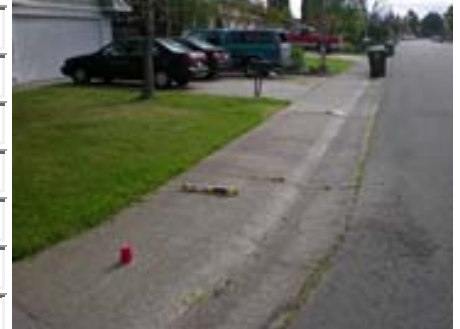
Barrier Type: Cross Slope - Existing (4.1% to 4.9%)

As Built Meas: 213 Quantity: LF

Description: Cross slope exceeds 2.0% (4.1% to 4.9%)

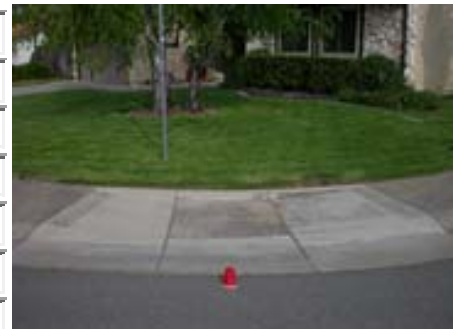
Barrier Type: 12" Grooves - Existing (>5.0%)

As Built Meas: 1 Quantity: EACH

Description: 12" grooves at top of curb ramp are not level (>5.0%)

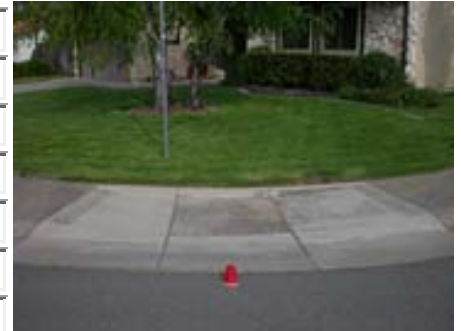
Field Date:	4/11/2011	Report Date:	4/11/2011	Barrier #:	6719B
Location:	Copperwood Dr and Escalante Wy - Corner A				
X Coordinate:	-121.26747				
Y Coordinate:	38.69645				
Barrier Area:	Curb Ramps				
Barrier Type:	Detectable Warnings - Truncated Domes				
Code Ref:	CBC 1127B.5.7 and ADA/ABA 705.1.3

As Built Meas:	1	Quantity:	EACH
Description:	No truncated domes provided at curb ramp		
As Built Desc:	No detectable warnings at curb ramp		
Solution:	Provide compliant truncated domes		
Bar. Severity:	2 Recommended	Cost Estimate:	\$0.00
Implementation Priority:	4	Facility Function:	
Implementation Phase:		Implementation Date:	
Official Responsible:			
Notes:	Two - way intersection corners A,B

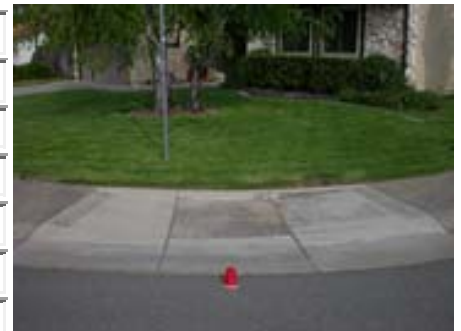
Field Date:	4/11/2011	Report Date:	4/11/2011	Barrier #:	6719C
Location:	Copperwood Dr and Escalante Wy - Corner A				
X Coordinate:	-121.26747				
Y Coordinate:	38.69645				
Barrier Area:	Curb Ramps				
Barrier Type:	Gutter Slope - Existing (6.6% to 8.2%)				
Code Ref:	CBC 1127B.5.3 and ADA/ABA 406.2

As Built Meas:	6	Quantity:	SF
Description:	Gutter slope exceeds 5.0% (6.6% to 8.2%)		
As Built Desc:	6.8% gutter slope		
Solution:	Demolish existing and construct new gutter		
Bar. Severity:	2 Recommended	Cost Estimate:	\$0.00
Implementation Priority:	4	Facility Function:	
Implementation Phase:		Implementation Date:	
Official Responsible:			
Notes:	Two - way intersection corners A,B

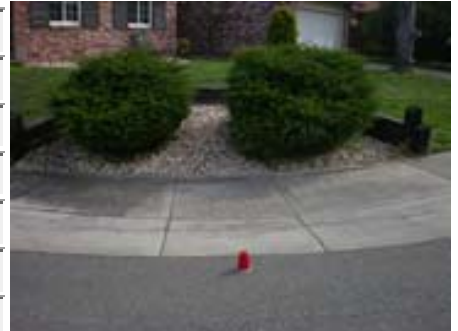
Field Date:	4/11/2011	Report Date:	4/11/2011	Barrier #:	6720A
Location:	Copperwood Dr and Escalante Wy - Corner B				
X Coordinate:	-121.26735				
Y Coordinate:	38.69645				
Barrier Area:	Curb Ramps				
Barrier Type:	12" Grooves - Existing (4.1% to 4.9%)				
Code Ref:	CBC 1127B.5.6

As Built Meas:	1	Quantity:	EACH
Description:	12" grooves at top of curb ramp are not level (4.1% to 4.9%)		
As Built Desc:	4.1% at 12" grooves		
Solution:	Demolish existing and construct new curb ramp		
Bar. Severity:	2 Recommended	Cost Estimate:	\$2,500.00
Implementation Priority:	4	Facility Function:	
Implementation Phase:		Implementation Date:	
Official Responsible:

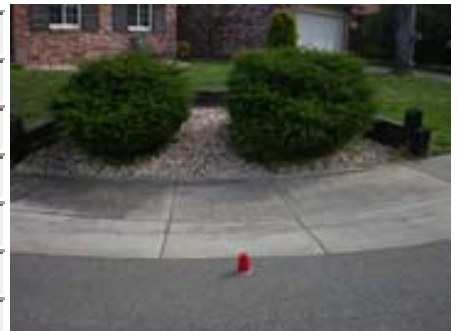
Field Date:	4/11/2011	Report Date:	4/11/2011	Barrier #:	6720B
Location:	Copperwood Dr and Escalante Wy - Corner B				
X Coordinate:	-121.26735				
Y Coordinate:	38.69645				
Barrier Area:	Curb Ramps				
Barrier Type:	Parallel Ramp Landing - Existing (4.1% to 4.9%)				
Code Ref:	CBC 1127B.5.4 and ADA/ABA 406.4

As Built Meas:	1	Quantity:	EACH
Description:	Curb ramp landing or pan not level(4.1% to 4.9%)		
As Built Desc:	4.1% landing slope		
Solution:	Demolish existing and construct new transition		
Bar. Severity:	2 Recommended	Cost Estimate:	\$0.00
Implementation Priority:	4	Facility Function:	
Implementation Phase:		Implementation Date:	
Official Responsible:

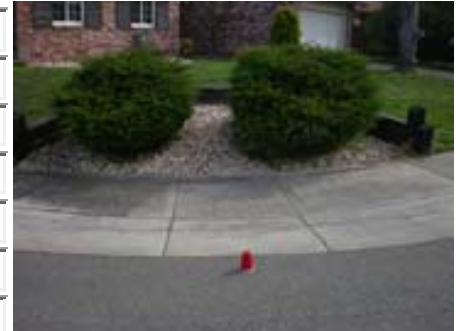
Field Date:	4/11/2011	Report Date:	4/11/2011	Barrier #:	6720C
Location:	Copperwood Dr and Escalante Wy - Corner B				
X Coordinate:	-121.26735				
Y Coordinate:	38.69645				
Barrier Area:	Curb Ramps				
Barrier Type:	Detectable Warnings - Truncated Domes				
Code Ref:	CBC 1127B.5.7 and ADA/ABA 705.1.3

As Built Meas:	1	Quantity:	EACH
Description:	No truncated domes provided at curb ramp		
As Built Desc:	No detectable warnings at curb ramp		
Solution:	Provide compliant truncated domes		
Bar. Severity:	2 Recommended	Cost Estimate:	\$0.00
Implementation Priority:	4	Facility Function:	
Implementation Phase:		Implementation Date:	
Official Responsible:			
Notes:	Two - way intersection corners A,B

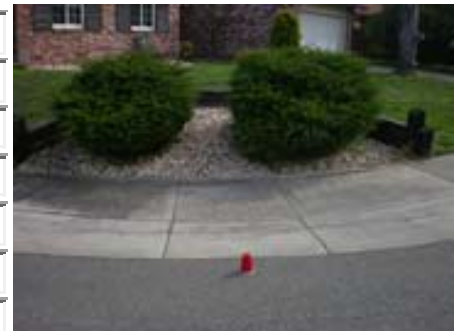
Field Date:	4/11/2011	Report Date:	4/11/2011	Barrier #:	6720D
Location:	Copperwood Dr and Escalante Wy - Corner B				
X Coordinate:	-121.26735				
Y Coordinate:	38.69645				
Barrier Area:	Curb Ramps				
Barrier Type:	Gutter Slope - Existing (8.3% or more)				
Code Ref:	CBC 1127B.5.3 and ADA/ABA 406.2

As Built Meas:	6	Quantity:	SF
Description:	Gutter slope exceeds 5.0% (8.3% or more)		
As Built Desc:	8.5% gutter slope		
Solution:	Demolish existing and construct new gutter		
Bar. Severity:	1 Necessary	Cost Estimate:	\$0.00
Implementation Priority:	4	Facility Function:	
Implementation Phase:		Implementation Date:	
Official Responsible:			
Notes:	Two - way intersection corners A,B

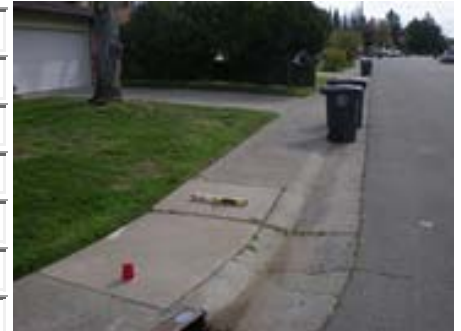
Barrier Type: Cross Slope - Existing (4.1% to 4.9%)

Description: Cross slope exceeds 2.0% (4.1% to 4.9%)

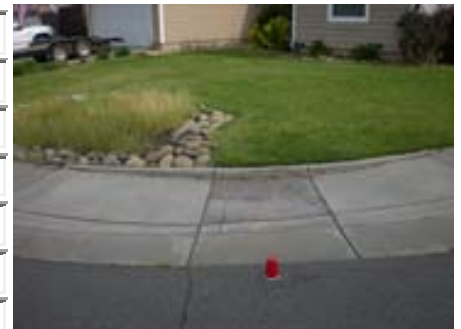
Barrier Type: 12" Grooves - Existing (>5.0%)

Description: 12" grooves at top of curb ramp are not level (>5.0%)

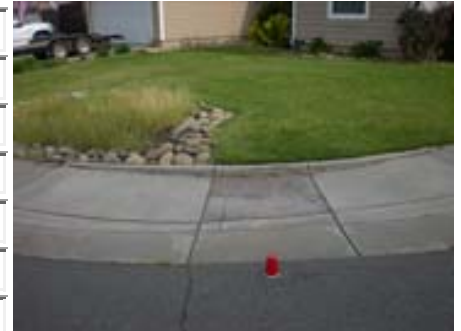
Barrier Type: Detectable Warnings - Truncated Domes

Description: No truncated domes provided at curb ramp

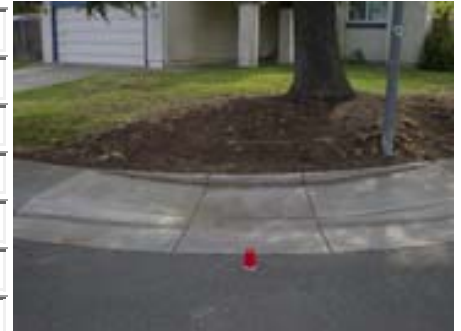
Field Date:	4/11/2011	Report Date:	4/11/2011	Barrier #:	6723A
Location:	Copperwood Dr and McClung Dr - Corner B				
X Coordinate:	-121.26515				
Y Coordinate:	38.69601				
Barrier Area:	Curb Ramps				
Barrier Type:	12" Grooves - Existing (>5.0%)				
Code Ref:	CBC 1127B.5.6

As Built Meas:	1	Quantity:	EACH
Description:	12" grooves at top of curb ramp are not level (>5.0%)		
As Built Desc:	6.1% at 12" grooves		
Solution:	Demolish existing and construct new curb ramp		
Bar. Severity:	1 Necessary	Cost Estimate:	\$2,500.00
Implementation Priority:	4	Facility Function:	
Implementation Phase:		Implementation Date:	
Official Responsible:

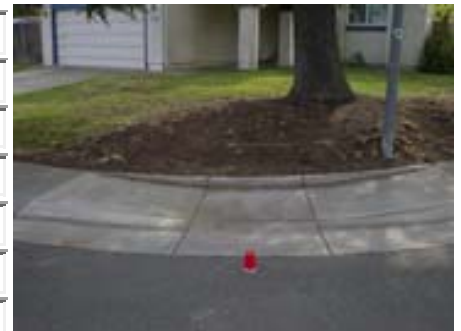
Field Date:	4/11/2011	Report Date:	4/11/2011	Barrier #:	6723B
Location:	Copperwood Dr and McClung Dr - Corner B				
X Coordinate:	-121.26515				
Y Coordinate:	38.69601				
Barrier Area:	Curb Ramps				
Barrier Type:	Parallel Ramp Landing - Existing (2.1% to 3.0%)				
Code Ref:	CBC 1127B.5.4 and ADA/ABA 406.4

As Built Meas:	1	Quantity:	EACH
Description:	Curb ramp landing or pan not level (2.1% to 3.0%)		
As Built Desc:	3.0% landing slope		
Solution:	Demolish existing and construct new transition		
Bar. Severity:	4 Low Severity	Cost Estimate:	\$0.00
Implementation Priority:	4	Facility Function:	
Implementation Phase:		Implementation Date:	
Official Responsible:

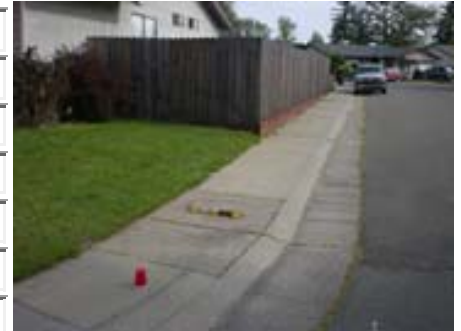
Barrier Type: Cross Slope - Existing (3.1% to 4.0%)

Description: Cross slope exceeds 2.0% (3.1% to 4.0%)

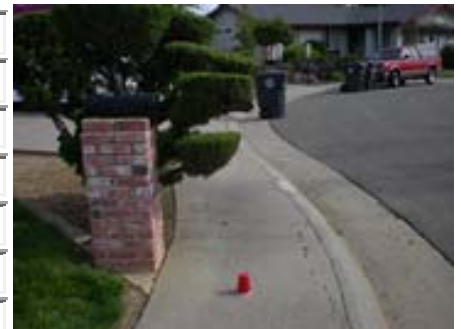
Barrier Type: Protruding Hazard

Description: Protruding object in route of travel between 27" and 80" high

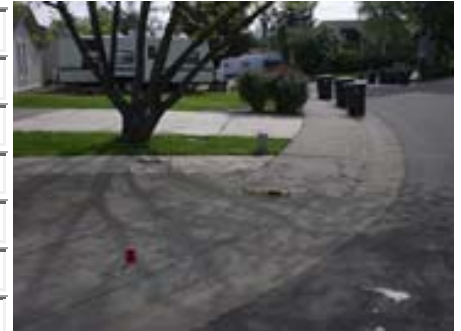
Field Date:	4/11/2011	Report Date:	4/11/2011	Barrier #:	6725
Location:	McClung Dr - North				
X Coordinate:	-121.26315				
Y Coordinate:	38.69655				
Barrier Area:	Sidewalks				
Barrier Type:	Cross Slope - Existing (3.1% to 4.0%)				
Code Ref:	CBC 1133B.7.1.3 and ADA/ABA 403.3

As Built Meas:	356	Quantity:	LF
Description:	Cross slope exceeds 2.0% (3.1% to 4.0%)		
As Built Desc:	3.5% cross slope		
Solution:	Demolish existing and construct new route		
Bar. Severity:	3 Hindrance	Cost Estimate:	\$44,500.00
Implementation Priority:	4	Facility Function:	
Implementation Phase:		Implementation Date:	
Official Responsible:

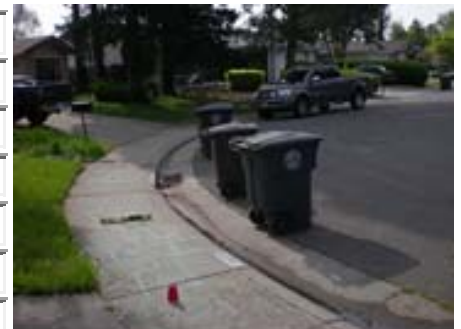
Field Date:	4/11/2011	Report Date:	4/11/2011	Barrier #:	6726
Location:	McClung Dr - East				
X Coordinate:	-121.26313				
Y Coordinate:	38.69584				
Barrier Area:	Sidewalks				
Barrier Type:	Cross Slope - Existing (3.1% to 4.0%)				
Code Ref:	CBC 1133B.7.1.3 and ADA/ABA 403.3

As Built Meas:	262	Quantity:	LF
Description:	Cross slope exceeds 2.0% (3.1% to 4.0%)		
As Built Desc:	3.8% cross slope		
Solution:	Demolish existing and construct new route		
Bar. Severity:	3 Hindrance	Cost Estimate:	\$32,750.00
Implementation Priority:	4	Facility Function:	
Implementation Phase:		Implementation Date:	
Official Responsible:

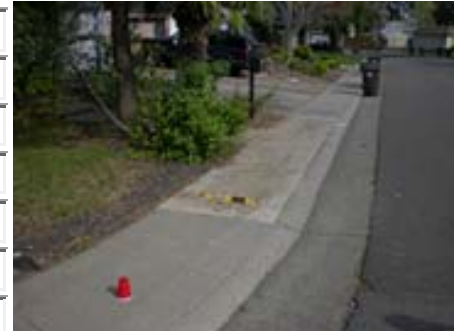
Field Date:	4/11/2011	Report Date:	4/11/2011	Barrier #:	6727
Location:	McClung Dr - West				
X Coordinate:	-121.26321				
Y Coordinate:	38.69638				
Barrier Area:	Sidewalks				
Barrier Type:	Cross Slope - Existing (4.1% to 4.9%)				
Code Ref:	CBC 1133B.7.1.3 and ADA/ABA 403.3

As Built Meas:	132	Quantity:	LF
Description:	Cross slope exceeds 2.0% (4.1% to 4.9%)		
As Built Desc:	4.1% cross slope		
Solution:	Demolish existing and construct new route		
Bar. Severity:	2 Recommended	Cost Estimate:	\$16,500.00
Implementation Priority:	4	Facility Function:	
Implementation Phase:		Implementation Date:	
Official Responsible:

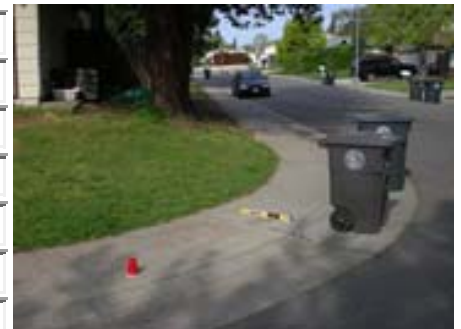
Field Date:	4/11/2011	Report Date:	4/11/2011	Barrier #:	6728
Location:	McClung Dr - South				
X Coordinate:	-121.26461				
Y Coordinate:	38.69634				
Barrier Area:	Sidewalks				
Barrier Type:	Cross Slope - Existing (4.1% to 4.9%)				
Code Ref:	CBC 1133B.7.1.3 and ADA/ABA 403.3

As Built Meas:	391	Quantity:	LF
Description:	Cross slope exceeds 2.0% (4.1% to 4.9%)		
As Built Desc:	4.1% cross slope		
Solution:	Demolish existing and construct new route		
Bar. Severity:	2 Recommended	Cost Estimate:	\$48,875.00
Implementation Priority:	4	Facility Function:	
Implementation Phase:		Implementation Date:	
Official Responsible:

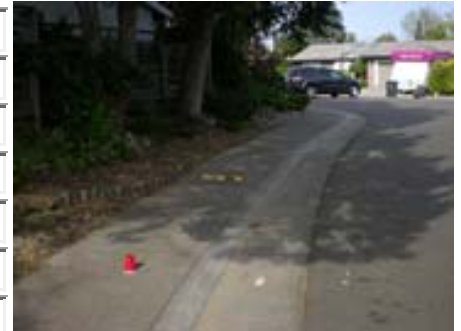
Field Date:	4/11/2011	Report Date:	4/11/2011	Barrier #:	6729
Location:	McClung Dr - South				
X Coordinate:	-121.2648				
Y Coordinate:	38.69632				
Barrier Area:	Sidewalks				
Barrier Type:	Cross Slope - Existing (4.1% to 4.9%)				
Code Ref:	CBC 1133B.7.1.3 and ADA/ABA 403.3

As Built Meas:	67	Quantity:	LF
Description:	Cross slope exceeds 2.0% (4.1% to 4.9%)		
As Built Desc:	4.1% cross slope		
Solution:	Demolish existing and construct new route		
Bar. Severity:	2 Recommended	Cost Estimate:	\$8,375.00
Implementation Priority:	4	Facility Function:	
Implementation Phase:		Implementation Date:	
Official Responsible:

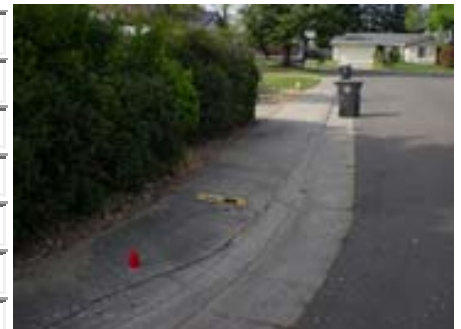
Field Date:	4/11/2011	Report Date:	4/11/2011	Barrier #:	6730
Location:	McClung Dr - East				
X Coordinate:	-121.26504				
Y Coordinate:	38.69612				
Barrier Area:	Sidewalks				
Barrier Type:	Cross Slope - Existing (5.0% or more)				
Code Ref:	CBC 1133B.7.1.3 and ADA/ABA 403.3

As Built Meas:	143	Quantity:	LF
Description:	Cross slope exceeds 2.0% (5.0% or more)		
As Built Desc:	5.0% cross slope		
Solution:	Demolish existing and construct new route		
Bar. Severity:	1 Necessary	Cost Estimate:	\$17,875.00
Implementation Priority:	4	Facility Function:	
Implementation Phase:		Implementation Date:	
Official Responsible:

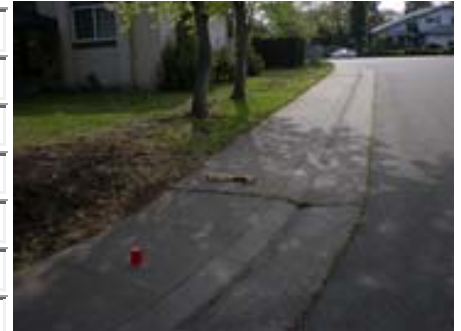
Field Date:	4/11/2011	Report Date:	4/11/2011	Barrier #:	6731A
Location:	Copperwood Dr - North				
X Coordinate:	-121.26505				
Y Coordinate:	38.69595				
Barrier Area:	Sidewalks				
Barrier Type:	Cross Slope - Existing (4.1% to 4.9%)				
Code Ref:	CBC 1133B.7.1.3 and ADA/ABA 403.3

As Built Meas:	594	Quantity:	LF
Description:	Cross slope exceeds 2.0% (4.1% to 4.9%)		
As Built Desc:	4.3% cross slope		
Solution:	Demolish existing and construct new route		
Bar. Severity:	2 Recommended	Cost Estimate:	\$74,250.00
Implementation Priority:	4	Facility Function:	
Implementation Phase:		Implementation Date:	
Official Responsible:			
Notes:

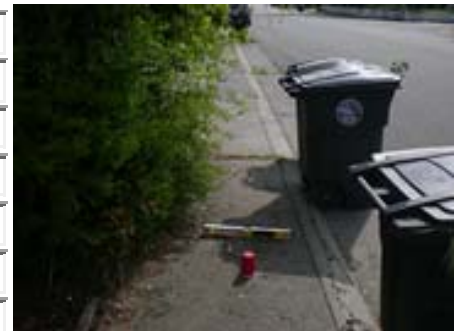
Field Date:	4/11/2011	Report Date:	4/11/2011	Barrier #:	6731B
Location:	Copperwood Dr - North				
X Coordinate:	-121.26426				
Y Coordinate:	38.69576				
Barrier Area:	Sidewalks				
Barrier Type:	Clear Width - Existing ($\leq 31"$ or less)				
Code Ref:	CBC 1133B.7.1

As Built Meas:	1	Quantity:	LF
Description:	Pedestrian route is not min. 48" wide ($\leq 31"$ or less)		
As Built Desc:	24" clear width due to foliage		
Solution:	Trim foliage to provide min. 48" clear width		
Bar. Severity:	1 Necessary	Cost Estimate:	\$125.00
Implementation Priority:	4	Facility Function:	
Implementation Phase:		Implementation Date:	
Official Responsible:			
Notes:

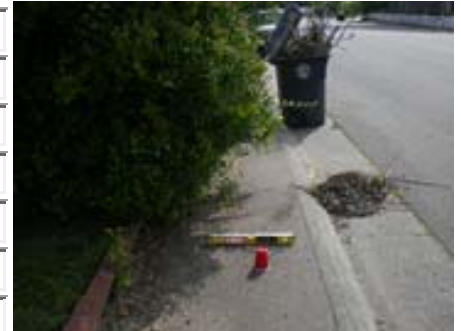
Field Date:	4/11/2011	Report Date:	4/11/2011	Barrier #:	6731C
Location:	Copperwood Dr - North				
X Coordinate:	-121.26406				
Y Coordinate:	38.69578				
Barrier Area:	Sidewalks				
Barrier Type:	Clear Width - Existing ($\leq 31"$ or less)				
Code Ref:	CBC 1133B.7.1

As Built Meas:	1	Quantity:	LF
Description:	Pedestrian route is not min. 48" wide ($\leq 31"$ or less)		
As Built Desc:	24" clear width due to foliage		
Solution:	Trim foliage to provide min. 48" clear width		
Bar. Severity:	1 Necessary	Cost Estimate:	\$125.00
Implementation Priority:	4	Facility Function:	
Implementation Phase:		Implementation Date:	
Official Responsible:

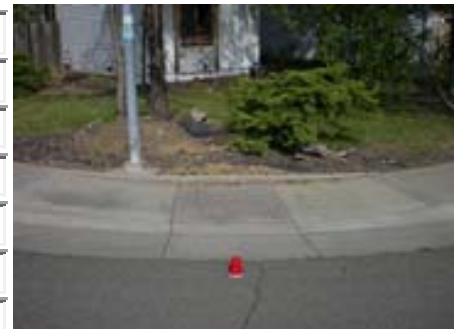
Field Date:	4/11/2011	Report Date:	4/11/2011	Barrier #:	6732A
Location:	Copperwood Dr and McClung Dr - Corner A				
X Coordinate:	-121.26314				
Y Coordinate:	38.69578				
Barrier Area:	Curb Ramps				
Barrier Type:	12" Grooves - Existing (4.1% to 4.9%)				
Code Ref:	CBC 1127B.5.6

As Built Meas:	1	Quantity:	EACH
Description:	12" grooves at top of curb ramp are not level (4.1% to 4.9%)		
As Built Desc:	4.8% at 12" grooves		
Solution:	Demolish existing and construct new curb ramp		
Bar. Severity:	2 Recommended	Cost Estimate:	\$2,500.00
Implementation Priority:	4	Facility Function:	
Implementation Phase:		Implementation Date:	
Official Responsible:

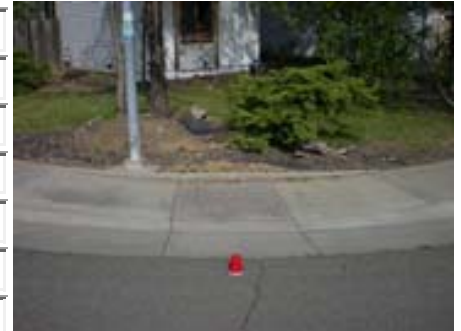
Field Date:	4/11/2011	Report Date:	4/11/2011	Barrier #:	6732B
Location:	Copperwood Dr and McClung Dr - Corner A				
X Coordinate:	-121.26314				
Y Coordinate:	38.69578				
Barrier Area:	Curb Ramps				
Barrier Type:	Detectable Warnings - Truncated Domes				
Code Ref:	CBC 1127B.5.7 and ADA/ABA 705.1.3

As Built Meas:	1	Quantity:	EACH
Description:	No truncated domes provided at curb ramp		
As Built Desc:	No detectable warnings at curb ramp		
Solution:	Provide compliant truncated domes		
Bar. Severity:	2 Recommended	Cost Estimate:	\$0.00
Implementation Priority:	4	Facility Function:	
Implementation Phase:		Implementation Date:	
Official Responsible:			
Notes:	Two - way intersection corners A,B

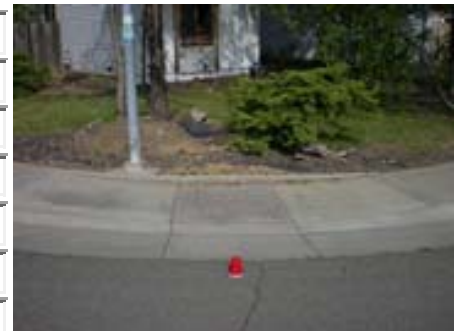
Field Date:	4/11/2011	Report Date:	4/11/2011	Barrier #:	6732C
Location:	Copperwood Dr and McClung Dr - Corner A				
X Coordinate:	-121.26314				
Y Coordinate:	38.69578				
Barrier Area:	Curb Ramps				
Barrier Type:	Gutter Slope - Existing (8.3% or more)				
Code Ref:	CBC 1127B.5.3 and ADA/ABA 406.2

As Built Meas:	6	Quantity:	SF
Description:	Gutter slope exceeds 5.0% (8.3% or more)		
As Built Desc:	8.3% gutter slope		
Solution:	Demolish existing and construct new gutter		
Bar. Severity:	1 Necessary	Cost Estimate:	\$0.00
Implementation Priority:	4	Facility Function:	
Implementation Phase:		Implementation Date:	
Official Responsible:			
Notes:	Two - way intersection corners A,B

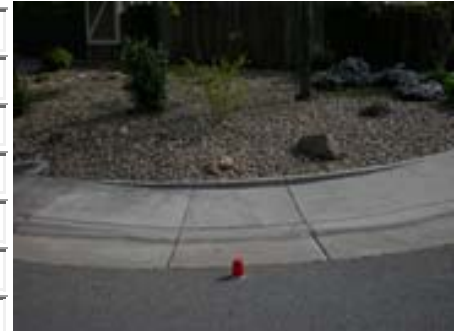
Field Date:	4/11/2011	Report Date:	4/11/2011	Barrier #:	6733A
Location:	Copperwood Dr and McClung Dr - Corner B				
X Coordinate:	-121.263				
Y Coordinate:	38.6958				
Barrier Area:	Curb Ramps				
Barrier Type:	12" Grooves - Existing (>5.0%)				
Code Ref:	CBC 1127B.5.6

As Built Meas:	1	Quantity:	EACH
Description:	12" grooves at top of curb ramp are not level (>5.0%)		
As Built Desc:	5.7% at 12" grooves		
Solution:	Demolish existing and construct new curb ramp		
Bar. Severity:	1 Necessary	Cost Estimate:	\$2,500.00
Implementation Priority:	4	Facility Function:	
Implementation Phase:		Implementation Date:	
Official Responsible:

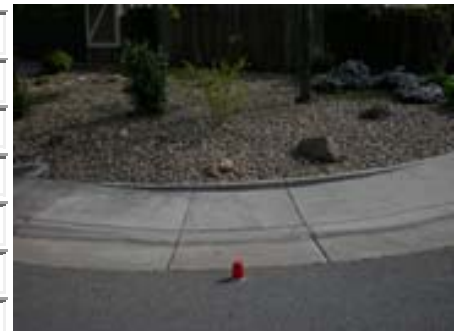
Field Date:	4/11/2011	Report Date:	4/11/2011	Barrier #:	6733B
Location:	Copperwood Dr and McClung Dr - Corner B				
X Coordinate:	-121.263				
Y Coordinate:	38.6958				
Barrier Area:	Curb Ramps				
Barrier Type:	Parallel Ramp Landing - Existing (3.1% to 4.0%)				
Code Ref:	CBC 1127B.5.4 and ADA/ABA 406.4

As Built Meas:	1	Quantity:	EACH
Description:	Curb ramp landing or pan not level (3.1% to 4.0%)		
As Built Desc:	3.7% landing slope		
Solution:	Demolish existing and construct new transition		
Bar. Severity:	3 Hindrance	Cost Estimate:	\$0.00
Implementation Priority:	4	Facility Function:	
Implementation Phase:		Implementation Date:	
Official Responsible:

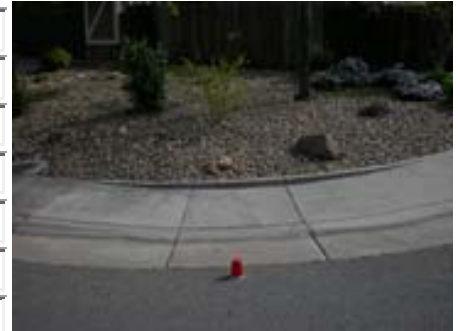
Field Date:	4/11/2011	Report Date:	4/11/2011	Barrier #:	6733C
Location:	Copperwood Dr and McClung Dr - Corner B				
X Coordinate:	-121.263				
Y Coordinate:	38.6958				
Barrier Area:	Curb Ramps				
Barrier Type:	Detectable Warnings - Truncated Domes				
Code Ref:	CBC 1127B.5.7 and ADA/ABA 705.1.3

As Built Meas:	1	Quantity:	EACH
Description:	No truncated domes provided at curb ramp		
As Built Desc:	No detectable warnings at curb ramp		
Solution:	Provide compliant truncated domes		
Bar. Severity:	2 Recommended	Cost Estimate:	\$0.00
Implementation Priority:	4	Facility Function:	
Implementation Phase:		Implementation Date:	
Official Responsible:			
Notes:	Two - way intersection corners A,B

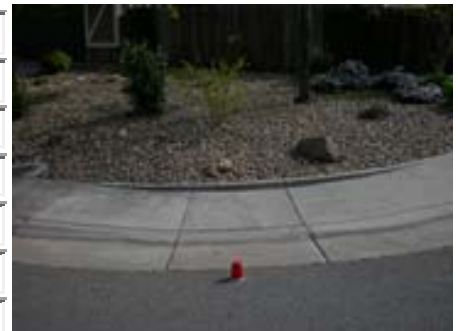
Field Date:	4/11/2011	Report Date:	4/11/2011	Barrier #:	6733D
Location:	Copperwood Dr and McClung Dr - Corner B				
X Coordinate:	-121.263				
Y Coordinate:	38.6958				
Barrier Area:	Curb Ramps				
Barrier Type:	Gutter Slope - Existing (8.3% or more)				
Code Ref:	CBC 1127B.5.3 and ADA/ABA 406.2

As Built Meas:	6	Quantity:	SF
Description:	Gutter slope exceeds 5.0% (8.3% or more)		
As Built Desc:	8.3% gutter slope		
Solution:	Demolish existing and construct new gutter		
Bar. Severity:	1 Necessary	Cost Estimate:	\$0.00
Implementation Priority:	4	Facility Function:	
Implementation Phase:		Implementation Date:	
Official Responsible:			
Notes:	Two - way intersection corners A,B

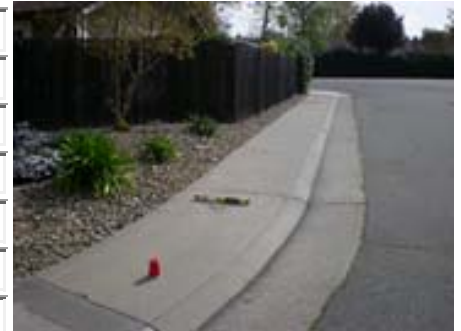
Field Date:	4/11/2011	Report Date:	4/11/2011	Barrier #:	6734
Location:	Copperwood Dr - North				
X Coordinate:	-121.26287				
Y Coordinate:	38.69582				
Barrier Area:	Sidewalks				
Barrier Type:	Cross Slope - Existing (3.1% to 4.0%)				
Code Ref:	CBC 1133B.7.1.3 and ADA/ABA 403.3

As Built Meas:	75	Quantity:	LF
Description:	Cross slope exceeds 2.0% (3.1% to 4.0%)		
As Built Desc:	3.1% cross slope		
Solution:	Demolish existing and construct new route		
Bar. Severity:	3 Hindrance	Cost Estimate:	\$9,375.00
Implementation Priority:	4	Facility Function:	
Implementation Phase:		Implementation Date:	
Official Responsible:			
Notes:

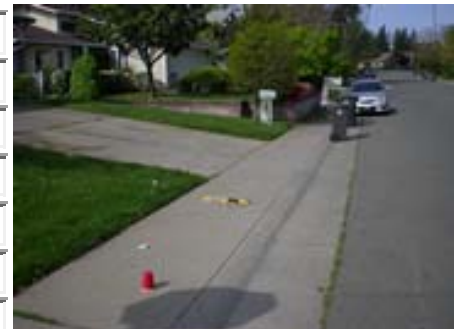
Field Date:	4/11/2011	Report Date:	4/11/2011	Barrier #:	6735
Location:	Copperwood Dr - South				
X Coordinate:	-121.26271				
Y Coordinate:	38.69569				
Barrier Area:	Sidewalks				
Barrier Type:	Cross Slope - Existing (3.1% to 4.0%)				
Code Ref:	CBC 1133B.7.1.3 and ADA/ABA 403.3

As Built Meas:	279	Quantity:	LF
Description:	Cross slope exceeds 2.0% (3.1% to 4.0%)		
As Built Desc:	3.6% cross slope		
Solution:	Demolish existing and construct new route		
Bar. Severity:	3 Hindrance	Cost Estimate:	\$34,875.00
Implementation Priority:	4	Facility Function:	
Implementation Phase:		Implementation Date:	
Official Responsible:			
Notes:

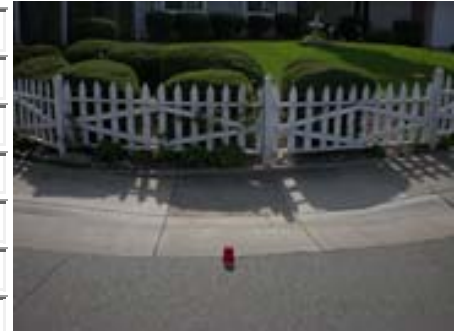
Field Date:	4/11/2011	Report Date:	4/11/2011	Barrier #:	6736A
Location:	Copperwood Dr and Cammeray Dr - Corner C				
X Coordinate:	-121.26368				
Y Coordinate:	38.69564				
Barrier Area:	Curb Ramps				
Barrier Type:	12" Grooves - Existing (3.1% to 4.0%)				
Code Ref:	CBC 1127B.5.6

As Built Meas:	1	Quantity:	EACH
Description:	12" grooves at top of curb ramp are not level (3.1% to 4.0%)		
As Built Desc:	3.9% at 12" grooves		
Solution:	Demolish existing and construct new curb ramp		
Bar. Severity:	3 Hindrance	Cost Estimate:	\$2,500.00
Implementation Priority:	4	Facility Function:	
Implementation Phase:		Implementation Date:	
Official Responsible:			
Notes:	Two - way intersection corners C,D

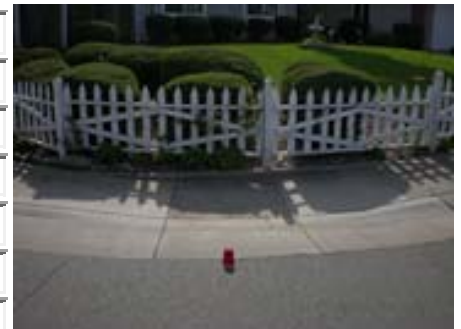
Field Date:	4/11/2011	Report Date:	4/11/2011	Barrier #:	6736B
Location:	Copperwood Dr and Cammeray Dr - Corner C				
X Coordinate:	-121.26368				
Y Coordinate:	38.69564				
Barrier Area:	Curb Ramps				
Barrier Type:	Cross Slope - New Construction				
Code Ref:	CBC 1127B.5.3 and ADA/ABA 406.2

As Built Meas:	1	Quantity:	EACH
Description:	Ramp run cross slope exceeds 2.0%		
As Built Desc:	3.5% cross slope		
Solution:	Demolish existing and construct new curb ramp		
Bar. Severity:	1 Necessary	Cost Estimate:	\$0.00
Implementation Priority:	4	Facility Function:	
Implementation Phase:		Implementation Date:	
Official Responsible:			
Notes:	Two - way intersection corners C,D

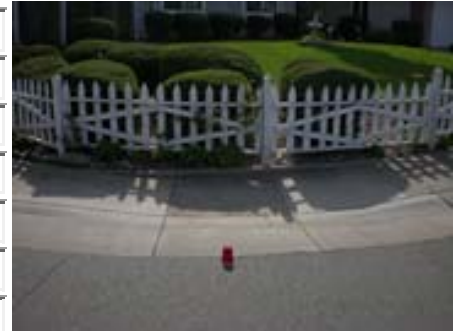
Field Date: 4/11/2011 Report Date: 4/11/2011 Barrier #: 6736C

Barrier Type: Detectable Warnings - Truncated Domes

Description: No truncated domes provided at curb ramp

Bar. Severity: 2 Recommended Cost Estimate: \$0.00 Status:

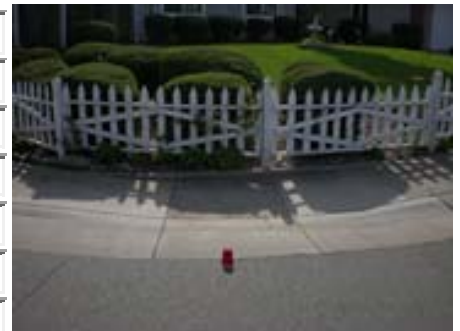
Barrier Type: Gutter Slope - Existing (6.6% to 8.2%)

Description: Gutter slope exceeds 5.0% (6.6% to 8.2%)

Bar. Severity: 2 Recommended Cost Estimate: \$0.00 Status:

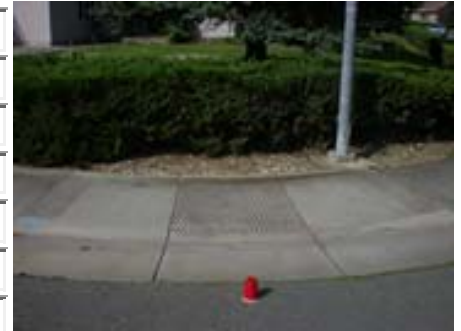
Field Date:	4/11/2011	Report Date:	4/11/2011	Barrier #:	6737A
Location:	Copperwood Dr and Cammeray Dr - Corner D				
X Coordinate:	-121.26378				
Y Coordinate:	38.69563				
Barrier Area:	Curb Ramps				
Barrier Type:	12" Grooves - Existing (>5.0%)				
Code Ref:	CBC 1127B.5.6

As Built Meas:	1	Quantity:	EACH
Description:	12" grooves at top of curb ramp are not level (>5.0%)		
As Built Desc:	6.8% at 12" grooves		
Solution:	Demolish existing and construct new curb ramp		
Bar. Severity:	1 Necessary	Cost Estimate:	\$2,500.00
Implementation Priority:	4	Facility Function:	
Implementation Phase:		Implementation Date:	
Official Responsible:			
Notes:	Two - way intersection corners C,D

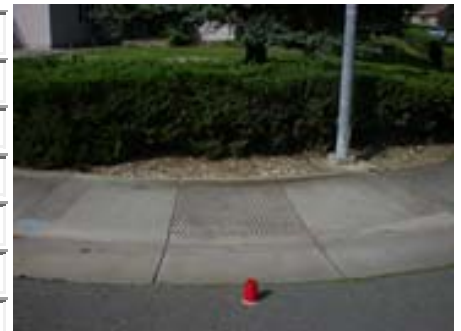
Field Date:	4/11/2011	Report Date:	4/11/2011	Barrier #:	6737B
Location:	Copperwood Dr and Cammeray Dr - Corner D				
X Coordinate:	-121.26378				
Y Coordinate:	38.69563				
Barrier Area:	Curb Ramps				
Barrier Type:	Cross Slope - Existing (3.1% to 4.0%)				
Code Ref:	CBC 1127B.5.3 and ADA/ABA 406.2

As Built Meas:	1	Quantity:	EACH
Description:	Ramp run cross slope exceeds 2.0% (3.1% to 4.0%)		
As Built Desc:	3.4% cross slope		
Solution:	Demolish existing and construct new curb ramp		
Bar. Severity:	3 Hindrance	Cost Estimate:	\$0.00
Implementation Priority:	4	Facility Function:	
Implementation Phase:		Implementation Date:	
Official Responsible:			
Notes:	Two - way intersection corners C,D

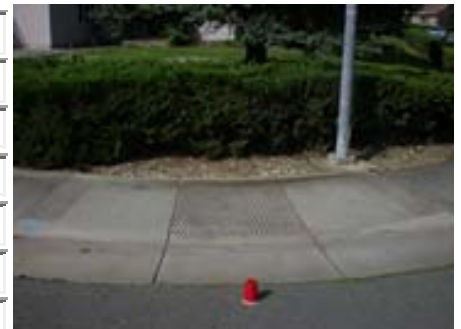
Field Date:	4/11/2011	Report Date:	4/11/2011	Barrier #:	6737D
Location:	Copperwood Dr and Cammeray Dr - Corner D				
X Coordinate:	-121.26378				
Y Coordinate:	38.69563				
Barrier Area:	Curb Ramps				
Barrier Type:	Gutter Slope - Existing (6.6% to 8.2%)				
Code Ref:	CBC 1127B.5.3 and ADA/ABA 406.2

As Built Meas:	6	Quantity:	SF
Description:	Gutter slope exceeds 5.0% (6.6% to 8.2%)		
As Built Desc:	8.2% gutter slope		
Solution:	Demolish existing and construct new gutter		
Bar. Severity:	2 Recommended	Cost Estimate:	\$0.00
Implementation Priority:	4	Facility Function:	
Implementation Phase:		Implementation Date:	
Official Responsible:			
Notes:	Two - way intersection corners C,D

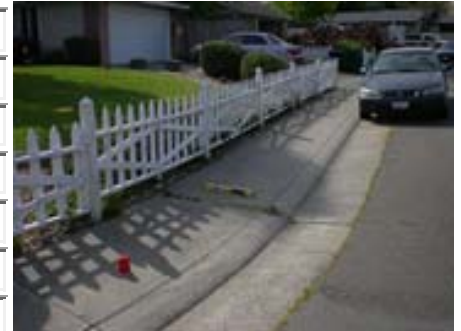
Field Date: 4/11/2011 Report Date: 4/11/2011 Barrier #: 6738

Barrier Type: Cross Slope - Existing (4.1% to 4.9%)

Description: Cross slope exceeds 2.0% (4.1% to 4.9%)

Bar. Severity: 2 Recommended Cost Estimate: \$18,375.00 Status:

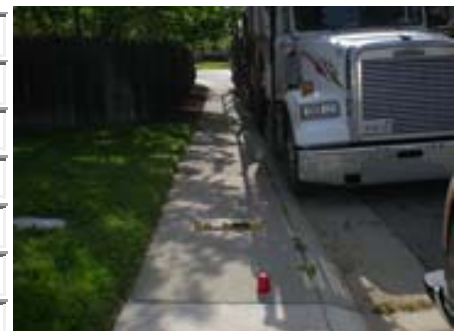
Barrier Type: Cross Slope - Existing (4.1% to 4.9%)

Description: Cross slope exceeds 2.0% (4.1% to 4.9%)

Bar. Severity: 2 Recommended Cost Estimate: \$12,625.00 Status:

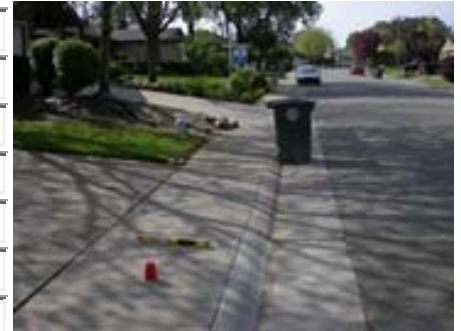
Field Date:	4/11/2011	Report Date:	4/11/2011	Barrier #:	6740
Location:	Poulson St - East				
X Coordinate:	-121.26289				
Y Coordinate:	38.69487				
Barrier Area:	Sidewalks				
Barrier Type:	Cross Slope - Existing (4.1% to 4.9%)				
Code Ref:	CBC 1133B.7.1.3 and ADA/ABA 403.3

As Built Meas:	373	Quantity:	LF
Description:	Cross slope exceeds 2.0% (4.1% to 4.9%)		
As Built Desc:	4.3% cross slope		
Solution:	Demolish existing and construct new route		
Bar. Severity:	2 Recommended	Cost Estimate:	\$46,625.00
Implementation Priority:	4	Facility Function:	
Implementation Phase:		Implementation Date:	
Official Responsible:

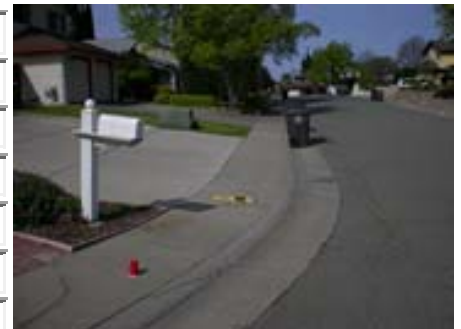
Field Date:	4/11/2011	Report Date:	4/11/2011	Barrier #:	6741
Location:	Poulson St - South				
X Coordinate:	-121.26314				
Y Coordinate:	38.69374				
Barrier Area:	Sidewalks				
Barrier Type:	Cross Slope - Existing (3.1% to 4.0%)				
Code Ref:	CBC 1133B.7.1.3 and ADA/ABA 403.3

As Built Meas:	398	Quantity:	LF
Description:	Cross slope exceeds 2.0% (3.1% to 4.0%)		
As Built Desc:	3.9% cross slope		
Solution:	Demolish existing and construct new route		
Bar. Severity:	3 Hindrance	Cost Estimate:	\$49,750.00
Implementation Priority:	4	Facility Function:	
Implementation Phase:		Implementation Date:	
Official Responsible:

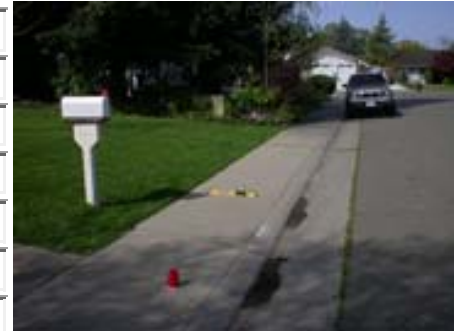
Barrier Type: Cross Slope - Existing (3.1% to 4.0%)

Description: Cross slope exceeds 2.0% (3.1% to 4.0%)

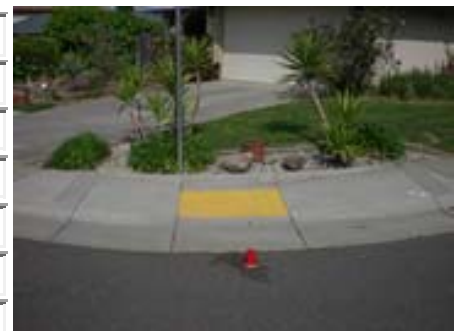
Barrier Type: 12" Grooves - Existing (3.1% to 4.0%)

Description: 12" grooves at top of curb ramp are not level (3.1% to 4.0%)

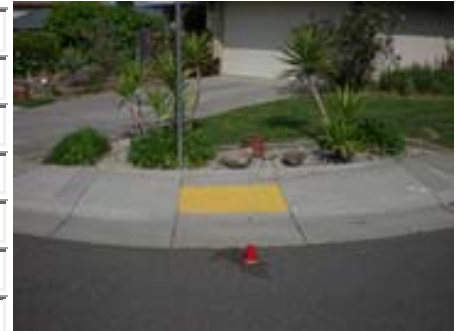
Field Date:	4/11/2011	Report Date:	4/11/2011	Barrier #:	6743B
Location:	Hoopes Dr and Baugh Ct - Corner A				
X Coordinate:	-121.26581				
Y Coordinate:	38.69499				
Barrier Area:	Curb Ramps				
Barrier Type:	Parallel Ramp Landing - Existing (2.1% to 3.0%)				
Code Ref:	CBC 1127B.5.4 and ADA/ABA 406.4

As Built Meas:	1	Quantity:	EACH
Description:	Curb ramp landing or pan not level (2.1% to 3.0%)		
As Built Desc:	3.0% landing slope		
Solution:	Demolish existing and construct new transition		
Bar. Severity:	4 Low Severity	Cost Estimate:	\$0.00
Implementation Priority:	4	Facility Function:	
Implementation Phase:		Implementation Date:	
Official Responsible:

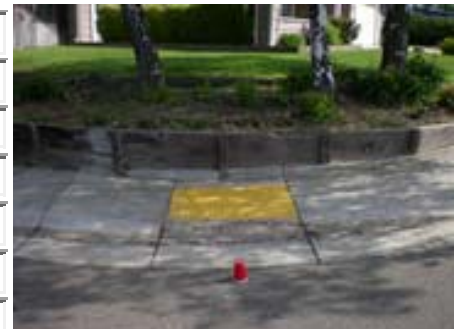
Field Date:	4/11/2011	Report Date:	4/11/2011	Barrier #:	6744A
Location:	Hoopes Dr and Baugh Ct - Corner B				
X Coordinate:	-121.26571				
Y Coordinate:	38.69499				
Barrier Area:	Curb Ramps				
Barrier Type:	12" Grooves - Existing (3.1% to 4.0%)				
Code Ref:	CBC 1127B.5.6

As Built Meas:	1	Quantity:	EACH
Description:	12" grooves at top of curb ramp are not level (3.1% to 4.0%)		
As Built Desc:	3.6% at 12" grooves		
Solution:	Demolish existing and construct new curb ramp		
Bar. Severity:	3 Hindrance	Cost Estimate:	\$2,500.00
Implementation Priority:	4	Facility Function:	
Implementation Phase:		Implementation Date:	
Official Responsible:

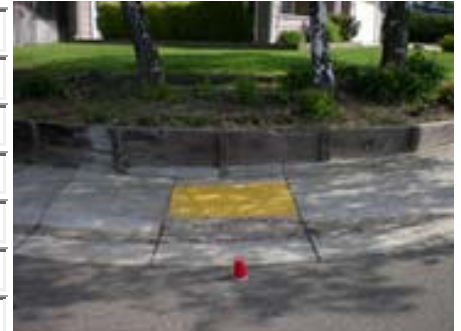
Barrier Type: 12" Grooves - Existing (3.1% to 4.0%)

Description: 12" grooves at top of curb ramp are not level (3.1% to 4.0%)
