DRAFT ADA TRANSITION PLAN UPDATE
NEIGHBORHOOD AREA 9 SONA
SEPTEMBER 20, 2011

CITY OF CITRUS HEIGHTS

The Sunrise Oaks Neighborhood Association (SONA)

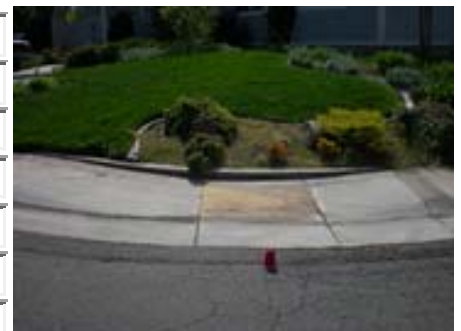
Barrier Type: 12" Grooves - Existing (3.1% to 4.0%)

Description: 12" grooves at top of curb ramp are not level (3.1% to 4.0%)

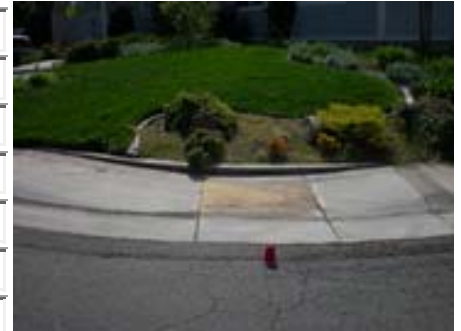
Barrier Type: Parallel Ramp Landing - Existing (3.1% to 4.0%)

Description: Curb ramp landing or pan not level (3.1% to 4.0%)

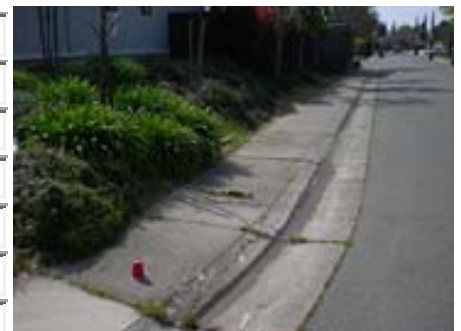
Barrier Type: Cross Slope - Existing (4.1% to 4.9%)

Description: Cross slope exceeds 2.0% (4.1% to 4.9%)

Bar. Severity: 2 Recommended Cost Estimate: \$23,625.00 Status:

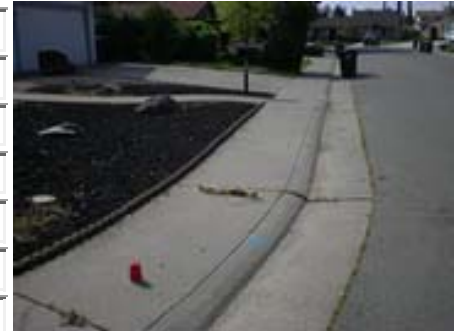
Field Date:	4/11/2011	Report Date:	4/11/2011	Barrier #:	6747
Location:	Poulson St - East				
X Coordinate:	-121.26565				
Y Coordinate:	38.69409				
Barrier Area:	Sidewalks				
Barrier Type:	Cross Slope - Existing (3.1% to 4.0%)				
Code Ref:	CBC 1133B.7.1.3 and ADA/ABA 403.3

As Built Meas:	214	Quantity:	LF
Description:	Cross slope exceeds 2.0% (3.1% to 4.0%)		
As Built Desc:	3.8% cross slope		
Solution:	Demolish existing and construct new route		
Bar. Severity:	3 Hindrance	Cost Estimate:	\$26,750.00
Implementation Priority:	4	Facility Function:	
Implementation Phase:		Implementation Date:	
Official Responsible:

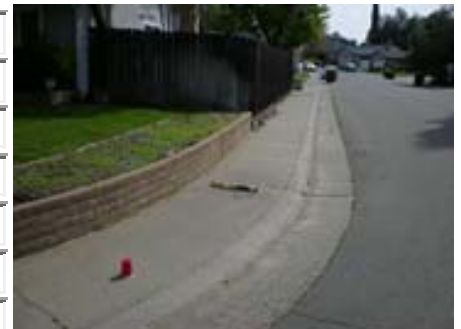
Field Date:	4/11/2011	Report Date:	4/11/2011	Barrier #:	6748
Location:	Poulson St - North				
X Coordinate:	-121.26561				
Y Coordinate:	38.69355				
Barrier Area:	Sidewalks				
Barrier Type:	Cross Slope - Existing (3.1% to 4.0%)				
Code Ref:	CBC 1133B.7.1.3 and ADA/ABA 403.3

As Built Meas:	565	Quantity:	LF
Description:	Cross slope exceeds 2.0% (3.1% to 4.0%)		
As Built Desc:	3.4% cross slope		
Solution:	Demolish existing and construct new route		
Bar. Severity:	3 Hindrance	Cost Estimate:	\$70,625.00
Implementation Priority:	4	Facility Function:	
Implementation Phase:		Implementation Date:	
Official Responsible:

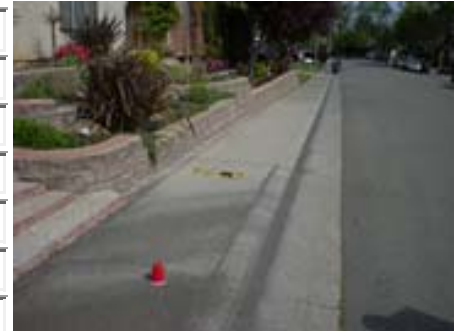
Field Date:	4/11/2011	Report Date:	4/11/2011	Barrier #:	6749
Location:	Poulson St - West				
X Coordinate:	-121.26301				
Y Coordinate:	38.69392				
Barrier Area:	Sidewalks				
Barrier Type:	Cross Slope - Existing (5.0% or more)				
Code Ref:	CBC 1133B.7.1.3 and ADA/ABA 403.3

As Built Meas:	351	Quantity:	LF
Description:	Cross slope exceeds 2.0% (5.0% or more)		
As Built Desc:	5.7% cross slope		
Solution:	Demolish existing and construct new route		
Bar. Severity:	1 Necessary	Cost Estimate:	\$43,875.00
Implementation Priority:	4	Facility Function:	
Implementation Phase:		Implementation Date:	
Official Responsible:

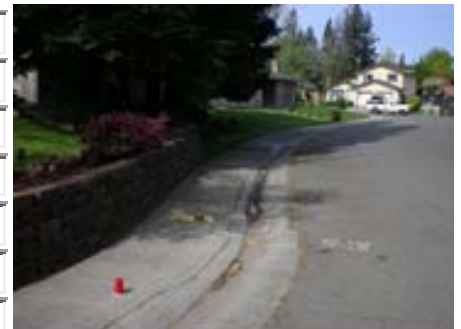
Field Date:	4/11/2011	Report Date:	4/11/2011	Barrier #:	6750
Location:	Poulson St - South				
X Coordinate:	-121.26316				
Y Coordinate:	38.69495				
Barrier Area:	Sidewalks				
Barrier Type:	Cross Slope - Existing (3.1% to 4.0%)				
Code Ref:	CBC 1133B.7.1.3 and ADA/ABA 403.3

As Built Meas:	181	Quantity:	LF
Description:	Cross slope exceeds 2.0% (3.1% to 4.0%)		
As Built Desc:	3.5% cross slope		
Solution:	Demolish existing and construct new route		
Bar. Severity:	3 Hindrance	Cost Estimate:	\$22,625.00
Implementation Priority:	4	Facility Function:	
Implementation Phase:		Implementation Date:	
Official Responsible:

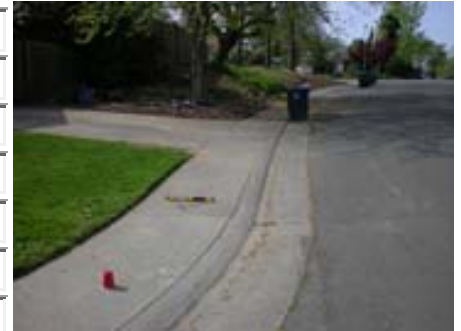
Field Date:	4/11/2011	Report Date:	4/11/2011	Barrier #:	6751
Location:	Cammeray Dr - East				
X Coordinate:	-121.26378				
Y Coordinate:	38.69504				
Barrier Area:	Sidewalks				
Barrier Type:	Cross Slope - Existing (3.1% to 4.0%)				
Code Ref:	CBC 1133B.7.1.3 and ADA/ABA 403.3

As Built Meas:	1511	Quantity:	LF
Description:	Cross slope exceeds 2.0% (3.1% to 4.0%)		
As Built Desc:	3.8% cross slope		
Solution:	Demolish existing and construct new route		
Bar. Severity:	3 Hindrance	Cost Estimate:	\$188,875.00
Implementation Priority:	4	Facility Function:	
Implementation Phase:		Implementation Date:	
Official Responsible:

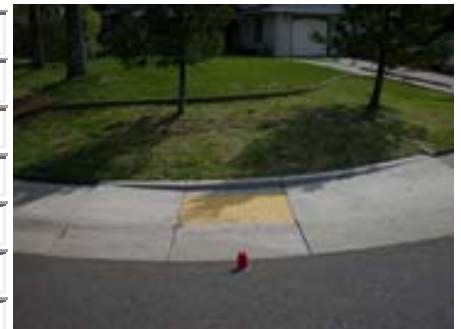
Field Date:	4/11/2011	Report Date:	4/11/2011	Barrier #:	6752A
Location:	Cammeray Dr and Cammeray Dr Ct - Corner B				
X Coordinate:	-121.26408				
Y Coordinate:	38.69471				
Barrier Area:	Curb Ramps				
Barrier Type:	12" Grooves - Existing (4.1% to 4.9%)				
Code Ref:	CBC 1127B.5.6

As Built Meas:	1	Quantity:	EACH
Description:	12" grooves at top of curb ramp are not level (4.1% to 4.9%)		
As Built Desc:	4.8% at 12" grooves		
Solution:	Demolish existing and construct new curb ramp		
Bar. Severity:	2 Recommended	Cost Estimate:	\$2,500.00
Implementation Priority:	4	Facility Function:	
Implementation Phase:		Implementation Date:	
Official Responsible:

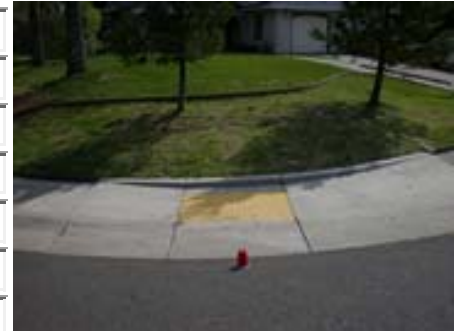
Field Date:	4/11/2011	Report Date:	4/11/2011	Barrier #:	6752B
Location:	Cammeray Dr and Cammeray Dr Ct - Corner B				
X Coordinate:	-121.26408				
Y Coordinate:	38.69471				
Barrier Area:	Curb Ramps				
Barrier Type:	Parallel Ramp Landing - Existing (3.1% to 4.0%)				
Code Ref:	CBC 1127B.5.4 and ADA/ABA 406.4

As Built Meas:	1	Quantity:	EACH
Description:	Curb ramp landing or pan not level (3.1% to 4.0%)		
As Built Desc:	3.6% landing slope		
Solution:	Demolish existing and construct new transition		
Bar. Severity:	3 Hindrance	Cost Estimate:	\$0.00
Implementation Priority:	4	Facility Function:	
Implementation Phase:		Implementation Date:	
Official Responsible:

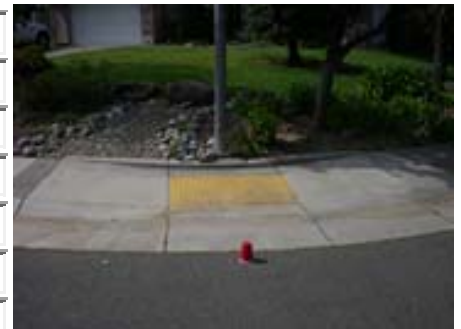
Field Date:	4/11/2011	Report Date:	4/11/2011	Barrier #:	6753
Location:	Cammeray Dr and Cammeray Dr Ct - Corner C				
X Coordinate:	-121.26418				
Y Coordinate:	38.69464				
Barrier Area:	Curb Ramps				
Barrier Type:	12" Grooves - Existing (3.1% to 4.0%)				
Code Ref:	CBC 1127B.5.6

As Built Meas:	1	Quantity:	EACH
Description:	12" grooves at top of curb ramp are not level (3.1% to 4.0%)		
As Built Desc:	3.1% at 12" grooves		
Solution:	Demolish existing and construct new curb ramp		
Bar. Severity:	3 Hindrance	Cost Estimate:	\$2,500.00
Implementation Priority:	4	Facility Function:	
Implementation Phase:		Implementation Date:	
Official Responsible:

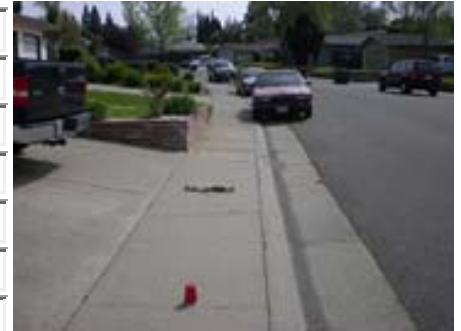
Barrier Type: Cross Slope - Existing (3.1% to 4.0%)

Code Ref: CBC 1133B.7.1.3 and ADA/ABA 403.3

As Built Meas: 253 Quantity: LF

Description: Cross slope exceeds 2.0% (3.1% to 4.0%)

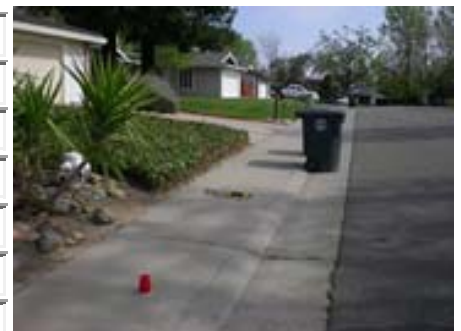
Barrier Type: Cross Slope - Existing (3.1% to 4.0%)

Code Ref: CBC 1133B.7.1.3 and ADA/ABA 403.3

As Built Meas: 480 Quantity: LF

Description: Cross slope exceeds 2.0% (3.1% to 4.0%)

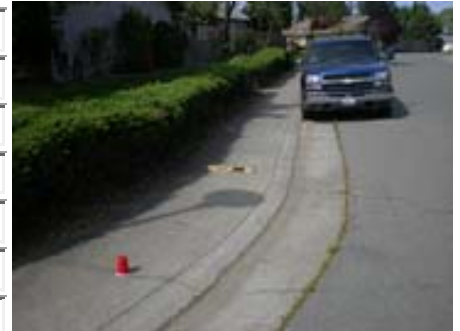
Field Date:	4/11/2011	Report Date:	4/11/2011	Barrier #:	6756
Location:	Cammeray Dr - South				
X Coordinate:	-121.26386				
Y Coordinate:	38.69563				
Barrier Area:	Sidewalks				
Barrier Type:	Cross Slope - Existing (3.1% to 4.0%)				
Code Ref:	CBC 1133B.7.1.3 and ADA/ABA 403.3

As Built Meas:	194	Quantity:	LF
Description:	Cross slope exceeds 2.0% (3.1% to 4.0%)		
As Built Desc:	3.1% cross slope		
Solution:	Demolish existing and construct new route		
Bar. Severity:	3 Hindrance	Cost Estimate:	\$24,250.00
Implementation Priority:	4	Facility Function:	
Implementation Phase:		Implementation Date:	
Official Responsible:

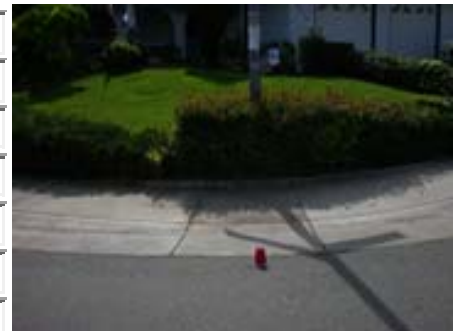
Field Date:	4/11/2011	Report Date:	4/11/2011	Barrier #:	6757A
Location:	Copperwood Dr and Hoopes Dr - Corner C				
X Coordinate:	-121.26456				
Y Coordinate:	38.69559				
Barrier Area:	Curb Ramps				
Barrier Type:	12" Grooves - Existing (3.1% to 4.0%)				
Code Ref:	CBC 1127B.5.6

As Built Meas:	1	Quantity:	EACH
Description:	12" grooves at top of curb ramp are not level (3.1% to 4.0%)		
As Built Desc:	3.5% at 12" grooves		
Solution:	Demolish existing and construct new curb ramp		
Bar. Severity:	3 Hindrance	Cost Estimate:	\$2,500.00
Implementation Priority:	4	Facility Function:	
Implementation Phase:		Implementation Date:	
Official Responsible:

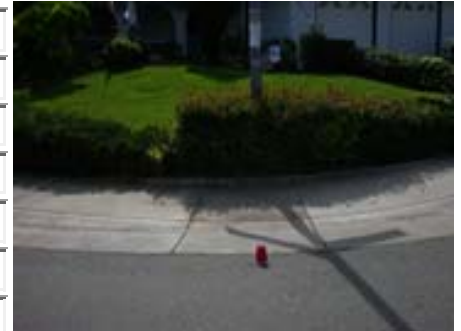
Field Date:	4/11/2011	Report Date:	4/11/2011	Barrier #:	6757B
Location:	Copperwood Dr and Hoopes Dr - Corner C				
X Coordinate:	-121.26456				
Y Coordinate:	38.69559				
Barrier Area:	Curb Ramps				
Barrier Type:	Detectable Warnings - Truncated Domes				
Code Ref:	CBC 1127B.5.7 and ADA/ABA 705.1.3

As Built Meas:	1	Quantity:	EACH
Description:	No truncated domes provided at curb ramp		
As Built Desc:	No detectable warnings at curb ramp		
Solution:	Provide compliant truncated domes		
Bar. Severity:	2 Recommended	Cost Estimate:	\$0.00
Implementation Priority:	4	Facility Function:	
Implementation Phase:		Implementation Date:	
Official Responsible:			
Notes:	Two - way intersection corners C,D

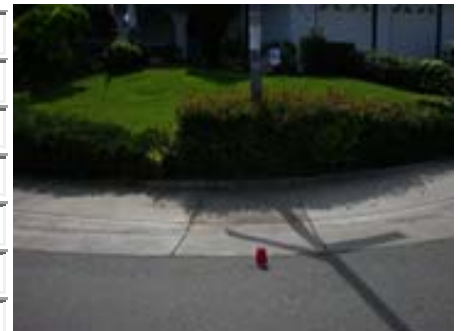
Field Date:	4/11/2011	Report Date:	4/11/2011	Barrier #:	6757C
Location:	Copperwood Dr and Hoopes Dr - Corner C				
X Coordinate:	-121.26456				
Y Coordinate:	38.69559				
Barrier Area:	Curb Ramps				
Barrier Type:	Gutter Slope - Existing (8.3% or more)				
Code Ref:	CBC 1127B.5.3 and ADA/ABA 406.2

As Built Meas:	6	Quantity:	SF
Description:	Gutter slope exceeds 5.0% (8.3% or more)		
As Built Desc:	11.5% gutter slope		
Solution:	Demolish existing and construct new gutter		
Bar. Severity:	1 Necessary	Cost Estimate:	\$0.00
Implementation Priority:	4	Facility Function:	
Implementation Phase:		Implementation Date:	
Official Responsible:			
Notes:	Two - way intersection corners C,D

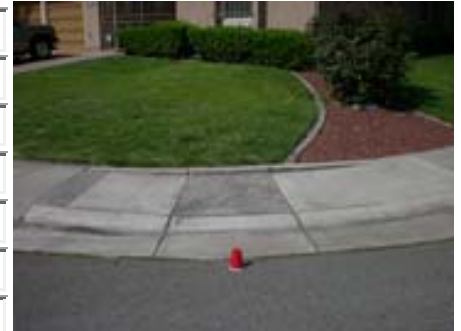
Field Date:	4/11/2011	Report Date:	4/11/2011	Barrier #:	6758A
Location:	Copperwood Dr and Hoopes Dr - Corner D				
X Coordinate:	-121.26472				
Y Coordinate:	38.69563				
Barrier Area:	Curb Ramps				
Barrier Type:	12" Grooves - Existing (4.1% to 4.9%)				
Code Ref:	CBC 1127B.5.6

As Built Meas:	1	Quantity:	EACH
Description:	12" grooves at top of curb ramp are not level (4.1% to 4.9%)		
As Built Desc:	4.2% at 12" grooves		
Solution:	Demolish existing and construct new curb ramp		
Bar. Severity:	2 Recommended	Cost Estimate:	\$2,500.00
Implementation Priority:	4	Facility Function:	
Implementation Phase:		Implementation Date:	
Official Responsible:			
Notes:	Two - way intersection corners C,D

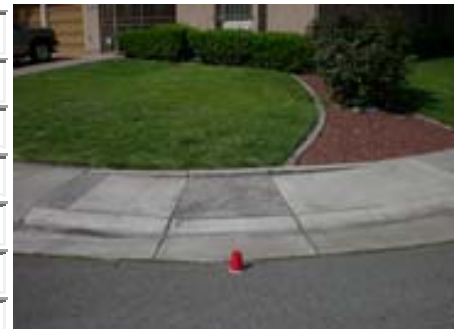
Field Date:	4/11/2011	Report Date:	4/11/2011	Barrier #:	6758B
Location:	Copperwood Dr and Hoopes Dr - Corner D				
X Coordinate:	-121.26472				
Y Coordinate:	38.69563				
Barrier Area:	Curb Ramps				
Barrier Type:	Detectable Warnings - Truncated Domes				
Code Ref:	CBC 1127B.5.7 and ADA/ABA 705.1.3

As Built Meas:	1	Quantity:	EACH
Description:	No truncated domes provided at curb ramp		
As Built Desc:	No detectable warnings at curb ramp		
Solution:	Provide compliant truncated domes		
Bar. Severity:	2 Recommended	Cost Estimate:	\$0.00
Implementation Priority:	4	Facility Function:	
Implementation Phase:		Implementation Date:	
Official Responsible:			
Notes:	Two - way intersection corners C,D

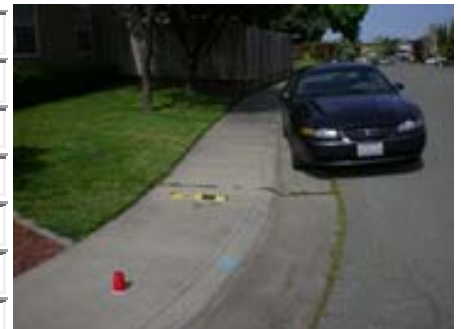
Barrier Type: Cross Slope - Existing (4.1% to 4.9%)

Code Ref: CBC 1133B.7.1.3 and ADA/ABA 403.3

As Built Meas: 1057 Quantity: LF

Description: Cross slope exceeds 2.0% (4.1% to 4.9%)

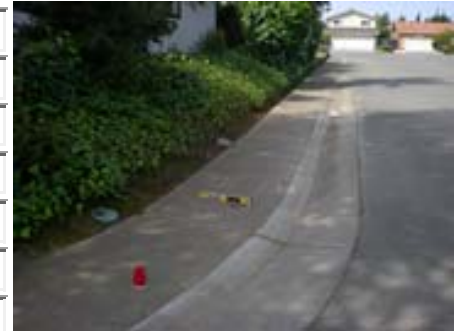
Field Date:	4/11/2011	Report Date:	4/11/2011	Barrier #:	6760
Location:	Copperwood Dr - South				
X Coordinate:	-121.26863				
Y Coordinate:	38.69631				
Barrier Area:	Sidewalks				
Barrier Type:	Cross Slope - Existing (3.1% to 4.0%)				
Code Ref:	CBC 1133B.7.1.3 and ADA/ABA 403.3

As Built Meas:	195	Quantity:	LF
Description:	Cross slope exceeds 2.0% (3.1% to 4.0%)		
As Built Desc:	3.8% cross slope		
Solution:	Demolish existing and construct new route		
Bar. Severity:	3 Hindrance	Cost Estimate:	\$24,375.00
Implementation Priority:	4	Facility Function:	
Implementation Phase:		Implementation Date:	
Official Responsible:

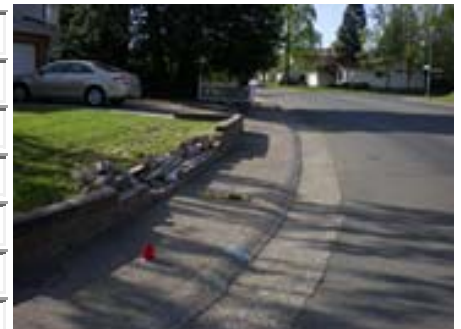
Field Date:	4/12/2011	Report Date:	4/12/2011	Barrier #:	6761
Location:	Canelo Hills Dr - East				
X Coordinate:	-121.2692				
Y Coordinate:	38.69622				
Barrier Area:	Sidewalks				
Barrier Type:	Cross Slope - Existing (3.1% to 4.0%)				
Code Ref:	CBC 1133B.7.1.3 and ADA/ABA 403.3

As Built Meas:	161	Quantity:	LF
Description:	Cross slope exceeds 2.0% (3.1% to 4.0%)		
As Built Desc:	3.8% cross slope		
Solution:	Demolish existing and construct new route		
Bar. Severity:	3 Hindrance	Cost Estimate:	\$20,125.00
Implementation Priority:	3	Facility Function:	
Implementation Phase:		Implementation Date:	
Official Responsible:

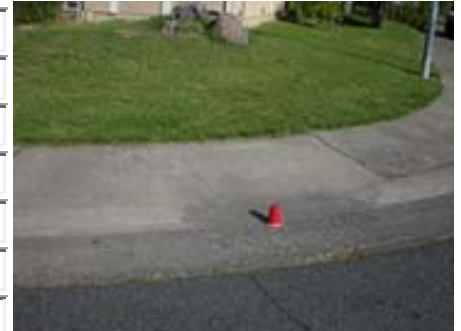
Field Date:	4/12/2011	Report Date:	4/12/2011	Barrier #:	6762
Location:	Canelo Hills Dr and Sundgarden Dr - Corner A				
X Coordinate:	-121.2693				
Y Coordinate:	38.69576				
Barrier Area:	Curb Ramps				
Barrier Type:	No Curb Ramp - Depressed Existing Curb				
Code Ref:	CBC 1127B.5.1 and ADA/ABA 402.2

As Built Meas:	1	Quantity:	EACH
Description:	No compliant curb cut at corner (intersection)		
As Built Desc:	9.9% running slope at depressed area		
Solution:	Demolish existing and construct curb cut		
Bar. Severity:	1 Necessary	Cost Estimate:	\$2,500.00
Implementation Priority:	3	Facility Function:	
Implementation Phase:		Implementation Date:	
Official Responsible:

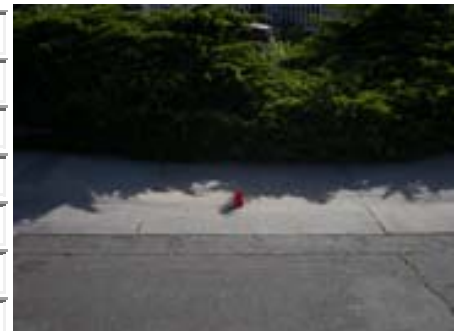
Field Date:	4/12/2011	Report Date:	4/12/2011	Barrier #:	6763A
Location:	Canelo Hills Dr and Sundgarden Dr - Corner B				
X Coordinate:	-121.26908				
Y Coordinate:	38.69574				
Barrier Area:	Curb Ramps				
Barrier Type:	Detectable Warnings - Truncated Domes				
Code Ref:	CBC 1127B.5.7 and ADA/ABA 705.1.3

As Built Meas:	1	Quantity:	EACH
Description:	No truncated domes provided at curb ramp		
As Built Desc:	No detectable warnings at curb ramp		
Solution:	Provide compliant truncated domes		
Bar. Severity:	2 Recommended	Cost Estimate:	\$1,400.00
Implementation Priority:	3	Facility Function:	
Implementation Phase:		Implementation Date:	
Official Responsible:

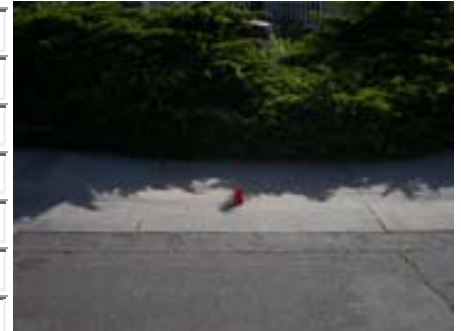
Field Date:	4/12/2011	Report Date:	4/12/2011	Barrier #:	6763B
Location:	Canelo Hills Dr and Sundgarden Dr - Corner B				
X Coordinate:	-121.26908				
Y Coordinate:	38.69574				
Barrier Area:	Curb Ramps				
Barrier Type:	Clear Width				
Code Ref:	CBC 1127B.5.2

As Built Meas:	1	Quantity:	LF
Description:	Curb ramp not at least 48" wide		
As Built Desc:	24" due to foliage		
Solution:	Trim foliage to provide min. 48" clear width		
Bar. Severity:	1 Necessary	Cost Estimate:	\$125.00
Implementation Priority:	3	Facility Function:	
Implementation Phase:		Implementation Date:	
Official Responsible:			
Notes:	Three - way intersection corners A, B, C

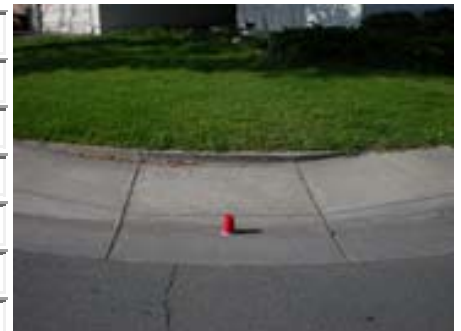
Field Date:	4/12/2011	Report Date:	4/12/2011	Barrier #:	6764
Location:	Canelo Hills Dr and Sundgarden Dr - Corner C				
X Coordinate:	-121.26919				
Y Coordinate:	38.69566				
Barrier Area:	Curb Ramps				
Barrier Type:	Detectable Warnings - Truncated Domes				
Code Ref:	CBC 1127B.5.7 and ADA/ABA 705.1.3

As Built Meas:	1	Quantity:	EACH
Description:	No truncated domes provided at curb ramp		
As Built Desc:	No detectable warnings at curb ramp		
Solution:	Provide compliant truncated domes		
Bar. Severity:	2 Recommended	Cost Estimate:	\$1,400.00
Implementation Priority:	3	Facility Function:	
Implementation Phase:		Implementation Date:	
Official Responsible:			
Notes:	Three - way intersection corners A, B, C

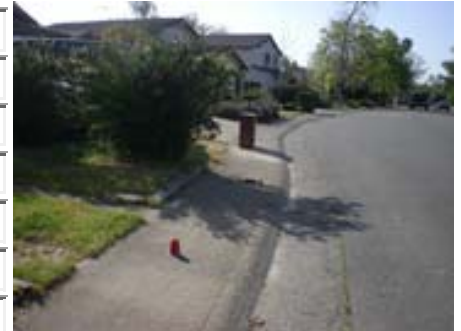
Barrier Type: Cross Slope - Existing (4.1% to 4.9%)

Code Ref: CBC 1133B.7.1.3 and ADA/ABA 403.3

As Built Meas: 374 Quantity: LF

Description: Cross slope exceeds 2.0% (4.1% to 4.9%)

Bar. Severity: 2 Recommended Cost Estimate: \$46,750.00 Status:

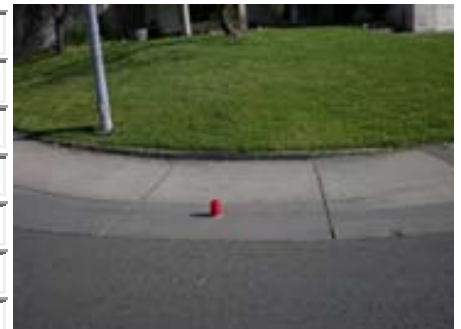
Barrier Type: 12" Grooves - Existing (>5.0%)

Code Ref: CBC 1127B.5.6

As Built Meas: 1 Quantity: EACH

Description: 12" grooves at top of curb ramp are not level (>5.0%)

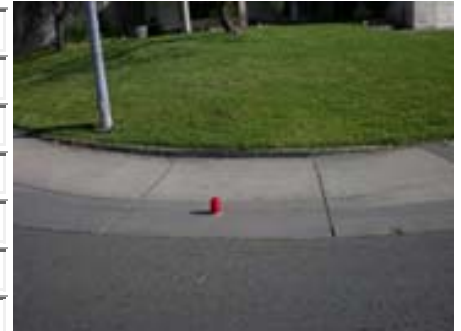
Field Date:	4/12/2011	Report Date:	4/12/2011	Barrier #:	6766B
Location:	Canelo Hills Dr and Hoopes Dr - Corner B				
X Coordinate:	-121.26853				
Y Coordinate:	38.69471				
Barrier Area:	Curb Ramps				
Barrier Type:	Parallel Ramp Landing - Existing (4.1% to 4.9%)				
Code Ref:	CBC 1127B.5.4 and ADA/ABA 406.4

As Built Meas:	1	Quantity:	EACH
Description:	Curb ramp landing or pan not level(4.1% to 4.9%)		
As Built Desc:	4.6% landing slope		
Solution:	Demolish existing and construct new transition		
Bar. Severity:	2 Recommended	Cost Estimate:	\$0.00
Implementation Priority:	3	Facility Function:	
Implementation Phase:		Implementation Date:	
Official Responsible:			
Notes:

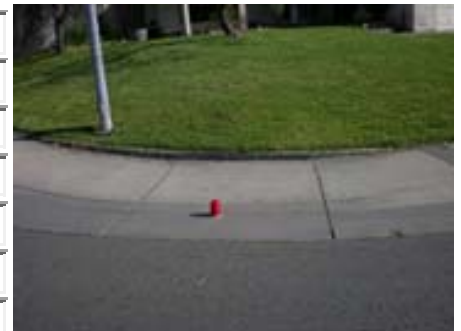
Field Date:	4/12/2011	Report Date:	4/12/2011	Barrier #:	6766C
Location:	Canelo Hills Dr and Hoopes Dr - Corner B				
X Coordinate:	-121.26853				
Y Coordinate:	38.69471				
Barrier Area:	Curb Ramps				
Barrier Type:	Detectable Warnings - Truncated Domes				
Code Ref:	CBC 1127B.5.7 and ADA/ABA 705.1.3

As Built Meas:	1	Quantity:	EACH
Description:	No truncated domes provided at curb ramp		
As Built Desc:	No detectable warnings at curb ramp		
Solution:	Provide compliant truncated domes		
Bar. Severity:	2 Recommended	Cost Estimate:	\$0.00
Implementation Priority:	3	Facility Function:	
Implementation Phase:		Implementation Date:	
Official Responsible:			
Notes:

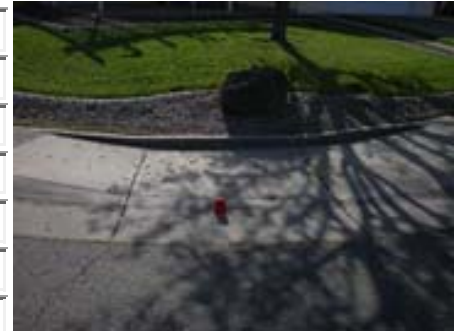
Field Date:	4/12/2011	Report Date:	4/12/2011	Barrier #:	6767A
Location:	Canelo Hills Dr and Hoopes Dr - Corner C				
X Coordinate:	-121.26851				
Y Coordinate:	38.6946				
Barrier Area:	Curb Ramps				
Barrier Type:	Parallel Ramp Landing - Existing (2.1% to 3.0%)				
Code Ref:	CBC 1127B.5.4 and ADA/ABA 406.4

As Built Meas:	1	Quantity:	EACH
Description:	Curb ramp landing or pan not level (2.1% to 3.0%)		
As Built Desc:	3.0% landing slope		
Solution:	Demolish existing and construct new transition		
Bar. Severity:	4 Low Severity	Cost Estimate:	\$250.00
Implementation Priority:	3	Facility Function:	
Implementation Phase:		Implementation Date:	
Official Responsible:			
Notes:

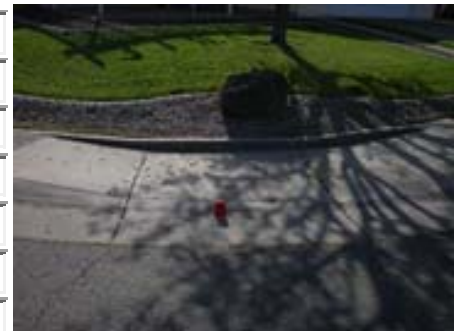
Field Date:	4/12/2011	Report Date:	4/12/2011	Barrier #:	6767B
Location:	Canelo Hills Dr and Hoopes Dr - Corner C				
X Coordinate:	-121.26851				
Y Coordinate:	38.6946				
Barrier Area:	Curb Ramps				
Barrier Type:	Detectable Warnings - Truncated Domes				
Code Ref:	CBC 1127B.5.7 and ADA/ABA 705.1.3

As Built Meas:	1	Quantity:	EACH
Description:	No truncated domes provided at curb ramp		
As Built Desc:	No detectable warnings at curb ramp		
Solution:	Provide compliant truncated domes		
Bar. Severity:	2 Recommended	Cost Estimate:	\$1,400.00
Implementation Priority:	3	Facility Function:	
Implementation Phase:		Implementation Date:	
Official Responsible:			
Notes:

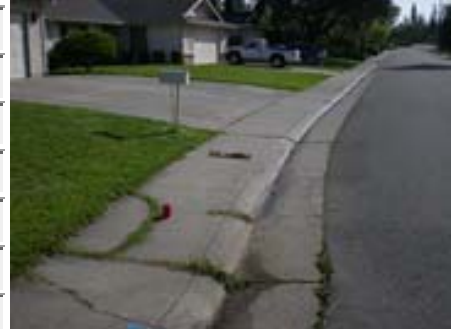
Field Date:	4/12/2011	Report Date:	4/12/2011	Barrier #:	6768A
Location:	Hoopes Dr - North				
X Coordinate:	-121.26847				
Y Coordinate:	38.69473				
Barrier Area:	Sidewalks				
Barrier Type:	Cross Slope - Existing (4.1% to 4.9%)				
Code Ref:	CBC 1133B.7.1.3 and ADA/ABA 403.3

As Built Meas:	183	Quantity:	LF
Description:	Cross slope exceeds 2.0% (4.1% to 4.9%)		
As Built Desc:	4.5% cross slope		
Solution:	Demolish existing and construct new route		
Bar. Severity:	2 Recommended	Cost Estimate:	\$22,875.00
Implementation Priority:	4	Facility Function:	
Implementation Phase:		Implementation Date:	
Official Responsible:

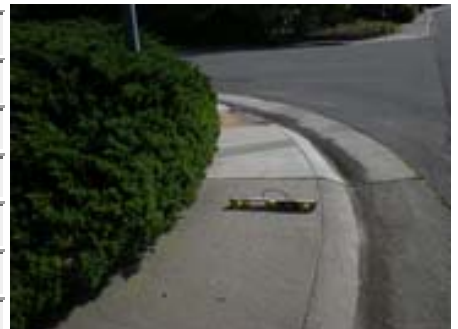
Field Date:	4/12/2011	Report Date:	4/12/2011	Barrier #:	6768B
Location:	Hoopes Dr - North				
X Coordinate:	-121.268				
Y Coordinate:	38.69478				
Barrier Area:	Sidewalks				
Barrier Type:	Clear Width - Existing ($\leq 31"$ or less)				
Code Ref:	CBC 1133B.7.1

As Built Meas:	1	Quantity:	LF
Description:	Pedestrian route is not min. 48" wide ($\leq 31"$ or less)		
As Built Desc:	24" clear width due to foliage		
Solution:	Trim foliage to provide min. 48" clear width		
Bar. Severity:	1 Necessary	Cost Estimate:	\$125.00
Implementation Priority:	4	Facility Function:	
Implementation Phase:		Implementation Date:	
Official Responsible:

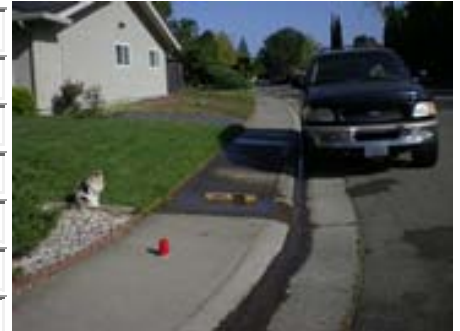
Field Date:	4/12/2011	Report Date:	4/12/2011	Barrier #:	6769
Location:	Camel Rock Wy - West				
X Coordinate:	-121.26794				
Y Coordinate:	38.69486				
Barrier Area:	Sidewalks				
Barrier Type:	Cross Slope - Existing (3.1% to 4.0%)				
Code Ref:	CBC 1133B.7.1.3 and ADA/ABA 403.3

As Built Meas:	554	Quantity:	LF
Description:	Cross slope exceeds 2.0% (3.1% to 4.0%)		
As Built Desc:	3.7% cross slope		
Solution:	Demolish existing and construct new route		
Bar. Severity:	3 Hindrance	Cost Estimate:	\$69,250.00
Implementation Priority:	4	Facility Function:	
Implementation Phase:		Implementation Date:	
Official Responsible:

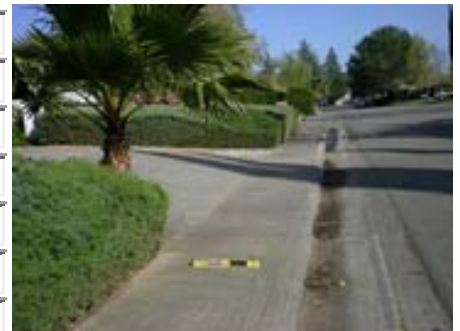
Field Date:	4/12/2011	Report Date:	4/12/2011	Barrier #:	6770
Location:	Camel Rock Wy - West				
X Coordinate:	-121.26799				
Y Coordinate:	38.69513				
Barrier Area:	Sidewalks				
Barrier Type:	Protruding Hazard				
Code Ref:	CBC 1133B.8.6.1 and ADA/ABA 307.2

As Built Meas:	1	Quantity:	JOB
Description:	Protruding object in route of travel between 27" and 80" high		
As Built Desc:	31" at tree branch		
Solution:	Remove object or provide detectable warning		
Bar. Severity:	1 Necessary	Cost Estimate:	\$1,400.00
Implementation Priority:	4	Facility Function:	
Implementation Phase:		Implementation Date:	
Official Responsible:

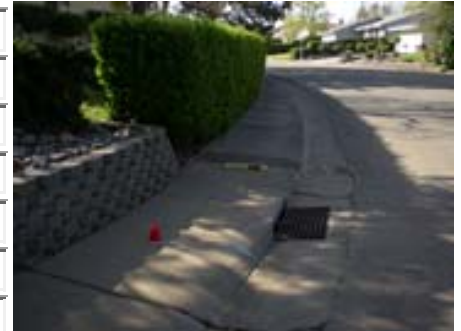
Barrier Type: Cross Slope - Existing (3.1% to 4.0%)

Description: Cross slope exceeds 2.0% (3.1% to 4.0%)

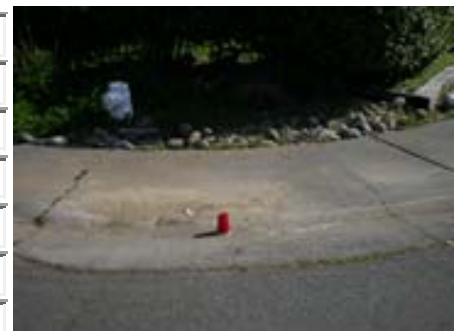
Barrier Type: No Curb Ramp - Depressed Existing Curb

Description: No compliant curb cut at corner (intersection)

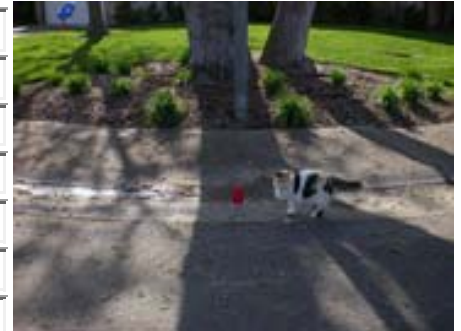
Field Date:	4/12/2011	Report Date:	4/12/2011	Barrier #:	6773
Location:	Camel Rock Wy and Cranmore Ct - Corner C				
X Coordinate:	-121.26792				
Y Coordinate:	38.69544				
Barrier Area:	Curb Ramps				
Barrier Type:	No Curb Ramp - Depressed Existing Curb				
Code Ref:	CBC 1127B.5.1 and ADA/ABA 402.2

As Built Meas:	1	Quantity:	EACH
Description:	No compliant curb cut at corner (intersection)		
As Built Desc:	12.5% running slope at depressed area		
Solution:	Demolish existing and construct curb cut		
Bar. Severity:	1 Necessary	Cost Estimate:	\$2,500.00
Implementation Priority:	4	Facility Function:	
Implementation Phase:		Implementation Date:	
Official Responsible:			
Notes:	Two - way intersection corners B,C

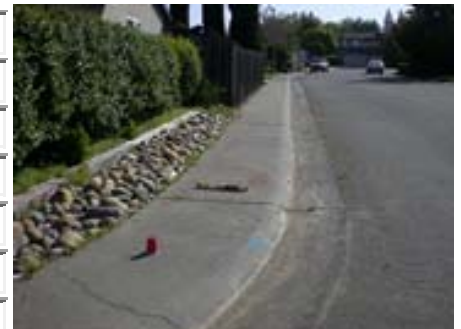
Field Date:	4/12/2011	Report Date:	4/12/2011	Barrier #:	6774
Location:	Cranmore Ct - North				
X Coordinate:	-121.2679				
Y Coordinate:	38.69554				
Barrier Area:	Sidewalks				
Barrier Type:	Cross Slope - Existing (4.1% to 4.9%)				
Code Ref:	CBC 1133B.7.1.3 and ADA/ABA 403.3

As Built Meas:	339	Quantity:	LF
Description:	Cross slope exceeds 2.0% (4.1% to 4.9%)		
As Built Desc:	4.2% cross slope		
Solution:	Demolish existing and construct new route		
Bar. Severity:	2 Recommended	Cost Estimate:	\$42,375.00
Implementation Priority:	4	Facility Function:	
Implementation Phase:		Implementation Date:	
Official Responsible:			
Notes:

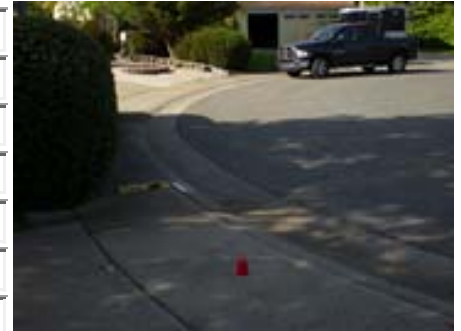
Field Date:	4/12/2011	Report Date:	4/12/2011	Barrier #:	6775A
Location:	Cranmore Ct - South				
X Coordinate:	-121.26683				
Y Coordinate:	38.69566				
Barrier Area:	Sidewalks				
Barrier Type:	Cross Slope - Existing (3.1% to 4.0%)				
Code Ref:	CBC 1133B.7.1.3 and ADA/ABA 403.3

As Built Meas:	3530	Quantity:	LF
Description:	Cross slope exceeds 2.0% (3.1% to 4.0%)		
As Built Desc:	3.5% cross slope		
Solution:	Demolish existing and construct new route		
Bar. Severity:	3 Hindrance	Cost Estimate:	\$441,250.00
Implementation Priority:	4	Facility Function:	
Implementation Phase:		Implementation Date:	
Official Responsible:

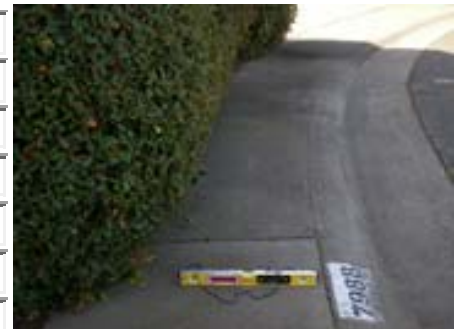
Field Date:	4/12/2011	Report Date:	4/12/2011	Barrier #:	6775B
Location:	Cranmore Ct - South				
X Coordinate:	-121.26683				
Y Coordinate:	38.69564				
Barrier Area:	Sidewalks				
Barrier Type:	Clear Width - Existing ($\leq 31"$ or less)				
Code Ref:	CBC 1133B.7.1

As Built Meas:	1	Quantity:	LF
Description:	Pedestrian route is not min. 48" wide ($\leq 31"$ or less)		
As Built Desc:	24" clear width due to foliage		
Solution:	Trim foliage to provide min. 48" clear width		
Bar. Severity:	1 Necessary	Cost Estimate:	\$125.00
Implementation Priority:	4	Facility Function:	
Implementation Phase:		Implementation Date:	
Official Responsible:

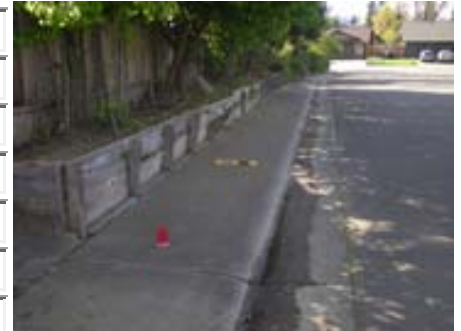
Field Date:	4/12/2011	Report Date:	4/12/2011	Barrier #:	6776A
Location:	Camel Rock Wy - East				
X Coordinate:	-121.26789				
Y Coordinate:	38.69533				
Barrier Area:	Sidewalks				
Barrier Type:	Cross Slope - Existing (3.1% to 4.0%)				
Code Ref:	CBC 1133B.7.1.3 and ADA/ABA 403.3

As Built Meas:	164	Quantity:	LF
Description:	Cross slope exceeds 2.0% (3.1% to 4.0%)		
As Built Desc:	3.5% cross slope		
Solution:	Demolish existing and construct new route		
Bar. Severity:	3 Hindrance	Cost Estimate:	\$20,500.00
Implementation Priority:	4	Facility Function:	
Implementation Phase:		Implementation Date:	
Official Responsible:

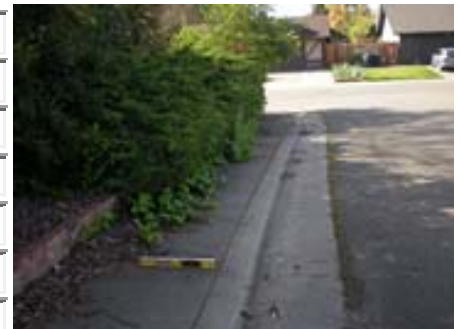
Field Date:	4/12/2011	Report Date:	4/12/2011	Barrier #:	6776B
Location:	Camel Rock Wy - East				
X Coordinate:	-121.26778				
Y Coordinate:	38.69503				
Barrier Area:	Sidewalks				
Barrier Type:	Clear Width - Existing ($\leq 31"$ or less)				
Code Ref:	CBC 1133B.7.1

As Built Meas:	1	Quantity:	LF
Description:	Pedestrian route is not min. 48" wide ($\leq 31"$ or less)		
As Built Desc:	24" clear width due to foliage		
Solution:	Trim foliage to provide min. 48" clear width		
Bar. Severity:	1 Necessary	Cost Estimate:	\$125.00
Implementation Priority:	4	Facility Function:	
Implementation Phase:		Implementation Date:	
Official Responsible:

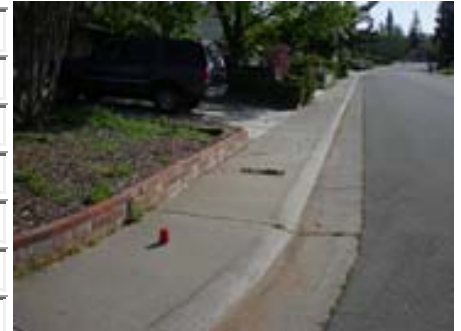
Field Date:	4/12/2011	Report Date:	4/12/2011	Barrier #:	6777
Location:	Hoopes Dr - North				
X Coordinate:	-121.26763				
Y Coordinate:	38.69484				
Barrier Area:	Sidewalks				
Barrier Type:	Cross Slope - Existing (4.1% to 4.9%)				
Code Ref:	CBC 1133B.7.1.3 and ADA/ABA 403.3

As Built Meas:	512	Quantity:	LF
Description:	Cross slope exceeds 2.0% (4.1% to 4.9%)		
As Built Desc:	4.1% cross slope		
Solution:	Demolish existing and construct new route		
Bar. Severity:	2 Recommended	Cost Estimate:	\$64,000.00
Implementation Priority:	4	Facility Function:	
Implementation Phase:		Implementation Date:	
Official Responsible:

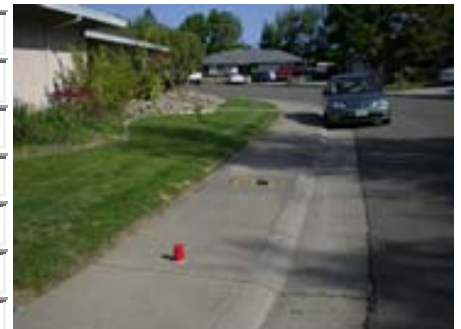
Field Date:	4/12/2011	Report Date:	4/12/2011	Barrier #:	6778
Location:	Baugh Ct - West				
X Coordinate:	-121.26586				
Y Coordinate:	38.69505				
Barrier Area:	Sidewalks				
Barrier Type:	Cross Slope - Existing (3.1% to 4.0%)				
Code Ref:	CBC 1133B.7.1.3 and ADA/ABA 403.3

As Built Meas:	222	Quantity:	LF
Description:	Cross slope exceeds 2.0% (3.1% to 4.0%)		
As Built Desc:	3.5% cross slope		
Solution:	Demolish existing and construct new route		
Bar. Severity:	3 Hindrance	Cost Estimate:	\$27,750.00
Implementation Priority:	4	Facility Function:	
Implementation Phase:		Implementation Date:	
Official Responsible:

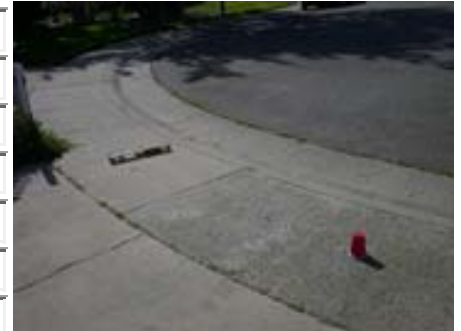
Barrier Type: Cross Slope - Existing (4.1% to 4.9%)

Description: Cross slope exceeds 2.0% (4.1% to 4.9%)

Bar. Severity: 2 Recommended Cost Estimate: \$29,250.00 Status:

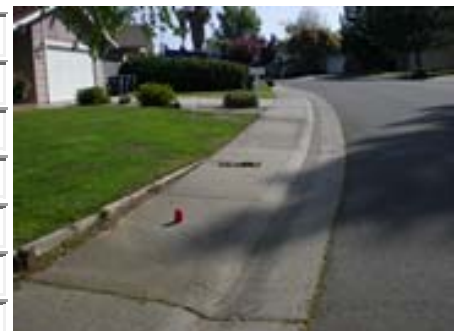
Barrier Type: Cross Slope - Existing (4.1% to 4.9%)

Description: Cross slope exceeds 2.0% (4.1% to 4.9%)

Bar. Severity: 2 Recommended Cost Estimate: \$44,875.00 Status:

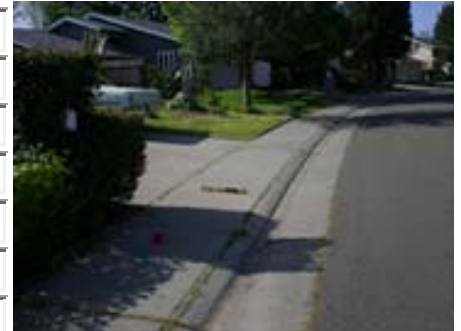
Field Date:	4/12/2011	Report Date:	4/12/2011	Barrier #:	6781
Location:	Hoopes Dr - East				
X Coordinate:	-121.2646				
Y Coordinate:	38.69554				
Barrier Area:	Sidewalks				
Barrier Type:	Cross Slope - Existing (3.1% to 4.0%)				
Code Ref:	CBC 1133B.7.1.3 and ADA/ABA 403.3

As Built Meas:	423	Quantity:	LF
Description:	Cross slope exceeds 2.0% (3.1% to 4.0%)		
As Built Desc:	3.2% cross slope		
Solution:	Demolish existing and construct new route		
Bar. Severity:	3 Hindrance	Cost Estimate:	\$52,875.00
Implementation Priority:	4	Facility Function:	
Implementation Phase:		Implementation Date:	
Official Responsible:

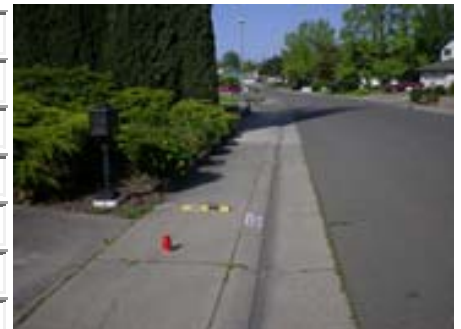
Field Date:	4/12/2011	Report Date:	4/12/2011	Barrier #:	6782
Location:	Hoopes Dr - South				
X Coordinate:	-121.26622				
Y Coordinate:	38.69487				
Barrier Area:	Sidewalks				
Barrier Type:	Cross Slope - Existing (3.1% to 4.0%)				
Code Ref:	CBC 1133B.7.1.3 and ADA/ABA 403.3

As Built Meas:	111	Quantity:	LF
Description:	Cross slope exceeds 2.0% (3.1% to 4.0%)		
As Built Desc:	3.1% cross slope		
Solution:	Demolish existing and construct new route		
Bar. Severity:	3 Hindrance	Cost Estimate:	\$13,875.00
Implementation Priority:	4	Facility Function:	
Implementation Phase:		Implementation Date:	
Official Responsible:

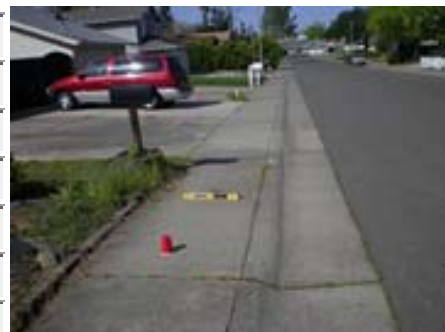
Barrier Type: Cross Slope - Existing (4.1% to 4.9%)

Description: Cross slope exceeds 2.0% (4.1% to 4.9%)

Bar. Severity: 2 Recommended

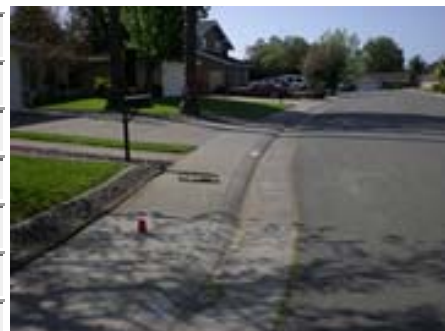
Barrier Type: Cross Slope - Existing (3.1% to 4.0%)

Description: Cross slope exceeds 2.0% (3.1% to 4.0%)

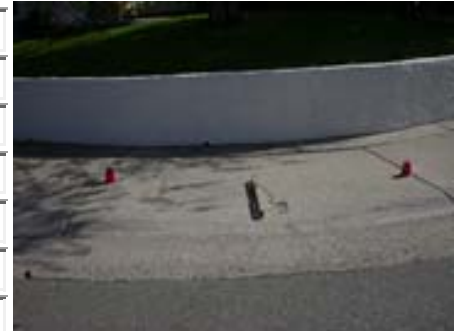
Barrier Type: Elbow in Sidewalk - Cross Slope (5.0% or more)

Description: Cross slope at elbow exceeds 2.0% (5.0% or more)

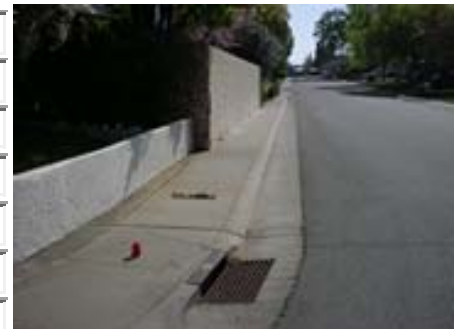
Barrier Type: Cross Slope - Existing (4.1% to 4.9%)

Description: Cross slope exceeds 2.0% (4.1% to 4.9%)

Bar. Severity: 2 Recommended Cost Estimate: \$27,875.00 Status:

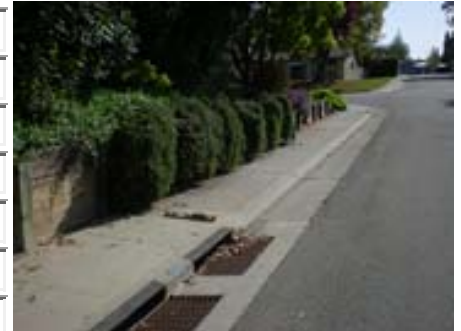
Field Date:	4/12/2011	Report Date:	4/12/2011	Barrier #:	6785B
Location:	Canelo Hills Dr - North				
X Coordinate:	-121.26798				
Y Coordinate:	38.6935				
Barrier Area:	Sidewalks				
Barrier Type:	Clear Width - Existing ($\leq 31"$ or less)				
Code Ref:	CBC 1133B.7.1

As Built Meas:	1	Quantity:	LF
Description:	Pedestrian route is not min. 48" wide ($\leq 31"$ or less)		
As Built Desc:	24" clear width due to foliage		
Solution:	Trim foliage to provide min. 48" clear width		
Bar. Severity:	1 Necessary	Cost Estimate:	\$125.00
Implementation Priority:	3	Facility Function:	
Implementation Phase:		Implementation Date:	
Official Responsible:

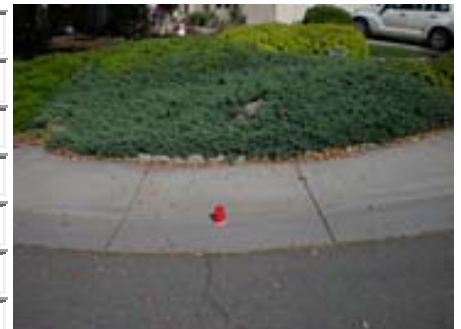
Field Date:	4/12/2011	Report Date:	4/12/2011	Barrier #:	6786A
Location:	Canelo Hills Dr and Hershberger Ct - Corner A				
X Coordinate:	-121.26768				
Y Coordinate:	38.69353				
Barrier Area:	Curb Ramps				
Barrier Type:	12" Grooves - Existing (4.1% to 4.9%)				
Code Ref:	CBC 1127B.5.6

As Built Meas:	1	Quantity:	EACH
Description:	12" grooves at top of curb ramp are not level (4.1% to 4.9%)		
As Built Desc:	4.2% at 12" grooves		
Solution:	Demolish existing and construct new curb ramp		
Bar. Severity:	2 Recommended	Cost Estimate:	\$2,500.00
Implementation Priority:	3	Facility Function:	
Implementation Phase:		Implementation Date:	
Official Responsible:

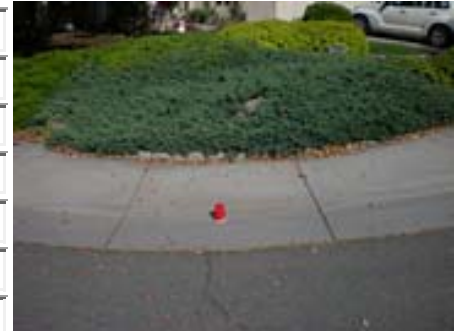
Barrier Type: Parallel Ramp Landing - Existing (>5.0% or more)

Description: Curb ramp landing or pan not level (>5.0% or more)

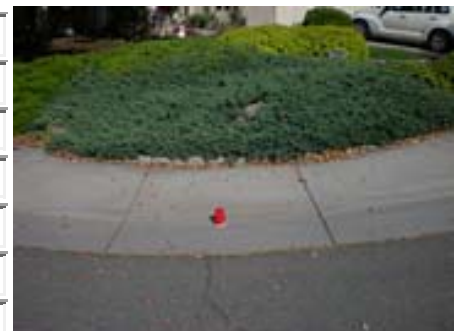
Barrier Type: Detectable Warnings - Truncated Domes

Description: No truncated domes provided at curb ramp

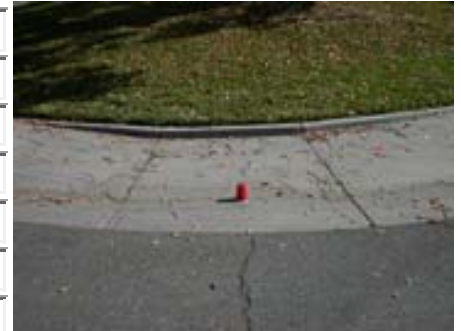
Field Date:	4/12/2011	Report Date:	4/12/2011	Barrier #:	6787A
Location:	Canelo Hills Dr and Hershberger Ct - Corner B				
X Coordinate:	-121.26752				
Y Coordinate:	38.69355				
Barrier Area:	Curb Ramps				
Barrier Type:	12" Grooves - Existing (3.1% to 4.0%)				
Code Ref:	CBC 1127B.5.6

As Built Meas:	1	Quantity:	EACH
Description:	12" grooves at top of curb ramp are not level (3.1% to 4.0%)		
As Built Desc:	3.9% at 12" grooves		
Solution:	Demolish existing and construct new curb ramp		
Bar. Severity:	3 Hindrance	Cost Estimate:	\$2,500.00
Implementation Priority:	3	Facility Function:	
Implementation Phase:		Implementation Date:	
Official Responsible:

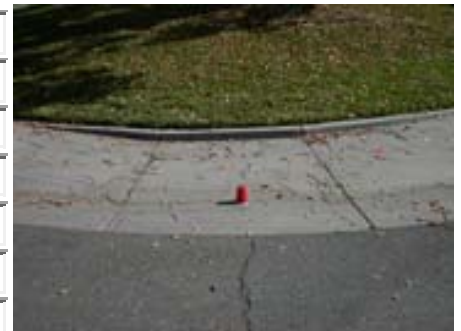
As Built Meas:	1	Quantity:	EACH
Description:	Curb ramp landing or pan not level (3.1% to 4.0%)		
As Built Desc:	3.9% landing slope		
Solution:	Demolish existing and construct new transition		
Bar. Severity:	3 Hindrance	Cost Estimate:	\$0.00
Implementation Priority:	3	Facility Function:	
Implementation Phase:		Implementation Date:	
Official Responsible:

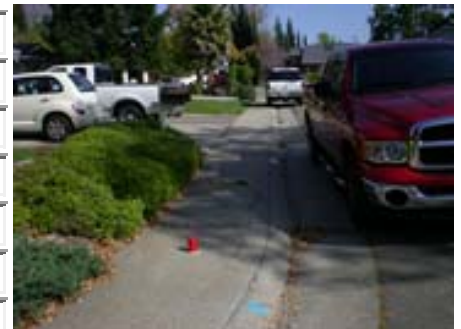
Barrier Type: Cross Slope - Existing (3.1% to 4.0%)

Description: Cross slope exceeds 2.0% (3.1% to 4.0%)

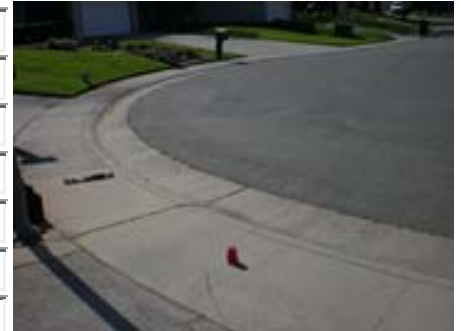
Barrier Type: Cross Slope - Existing (3.1% to 4.0%)

Description: Cross slope exceeds 2.0% (3.1% to 4.0%)

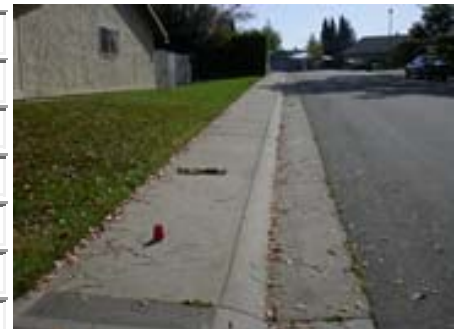
Barrier Type: Cross Slope - Existing (4.1% to 4.9%)

Description: Cross slope exceeds 2.0% (4.1% to 4.9%)

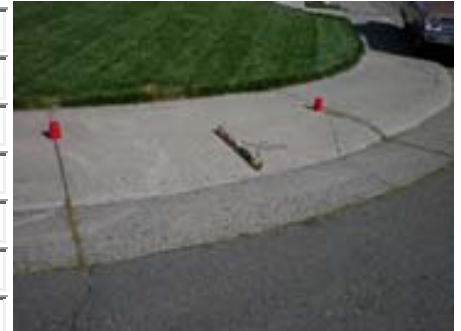
Field Date:	4/12/2011	Report Date:	4/12/2011	Barrier #:	6790B
Location:	Canelo Hills Dr - North				
X Coordinate:	-121.26672				
Y Coordinate:	38.69356				
Barrier Area:	Sidewalks				
Barrier Type:	Elbow in Sidewalk - Cross Slope (5.0% or more)				
Code Ref:	CBC 1133B.7.1.3 and ADA/ABA 403.3

As Built Meas:	6	Quantity:	LF
Description:	Cross slope at elbow exceeds 2.0% (5.0% or more)		
As Built Desc:	12.8% cross slope		
Solution:	Demolish existing and construct new sidewalk without curb ramp		
Bar. Severity:	1 Necessary	Cost Estimate:	\$750.00
Implementation Priority:	3	Facility Function:	
Implementation Phase:		Implementation Date:	
Official Responsible:

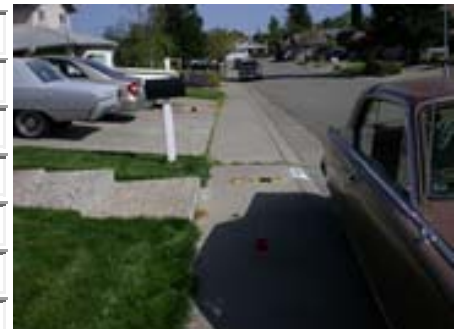
Field Date:	4/12/2011	Report Date:	4/12/2011	Barrier #:	6791
Location:	Canelo Hills Dr - West				
X Coordinate:	-121.26671				
Y Coordinate:	38.69362				
Barrier Area:	Sidewalks				
Barrier Type:	Cross Slope - Existing (4.1% to 4.9%)				
Code Ref:	CBC 1133B.7.1.3 and ADA/ABA 403.3

As Built Meas:	451	Quantity:	LF
Description:	Cross slope exceeds 2.0% (4.1% to 4.9%)		
As Built Desc:	4.2% cross slope		
Solution:	Demolish existing and construct new route		
Bar. Severity:	2 Recommended	Cost Estimate:	\$56,375.00
Implementation Priority:	3	Facility Function:	
Implementation Phase:		Implementation Date:	
Official Responsible:

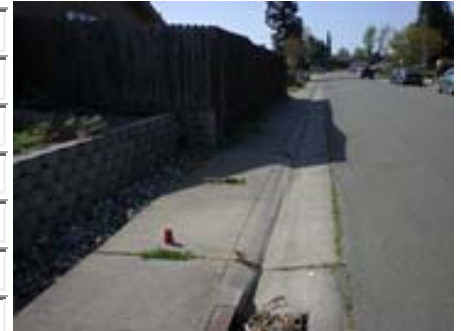
Field Date:	4/12/2011	Report Date:	4/12/2011	Barrier #:	6792
Location:	Canelo Hills Dr - East				
X Coordinate:	-121.26663				
Y Coordinate:	38.69478				
Barrier Area:	Sidewalks				
Barrier Type:	Cross Slope - Existing (3.1% to 4.0%)				
Code Ref:	CBC 1133B.7.1.3 and ADA/ABA 403.3

As Built Meas:	514	Quantity:	LF
Description:	Cross slope exceeds 2.0% (3.1% to 4.0%)		
As Built Desc:	3.8% cross slope		
Solution:	Demolish existing and construct new route		
Bar. Severity:	3 Hindrance	Cost Estimate:	\$64,250.00
Implementation Priority:	3	Facility Function:	
Implementation Phase:		Implementation Date:	
Official Responsible:

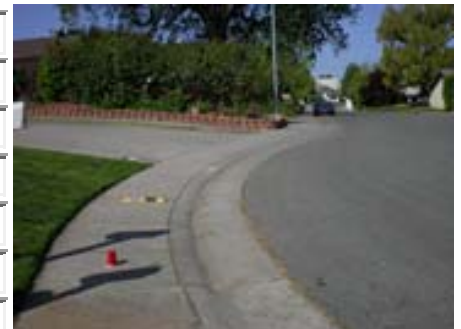
Field Date:	4/12/2011	Report Date:	4/12/2011	Barrier #:	6793
Location:	Canelo Hills Dr - South				
X Coordinate:	-121.26667				
Y Coordinate:	38.69342				
Barrier Area:	Sidewalks				
Barrier Type:	Cross Slope - Existing (4.1% to 4.9%)				
Code Ref:	CBC 1133B.7.1.3 and ADA/ABA 403.3

As Built Meas:	598	Quantity:	LF
Description:	Cross slope exceeds 2.0% (4.1% to 4.9%)		
As Built Desc:	4.3% cross slope		
Solution:	Demolish existing and construct new route		
Bar. Severity:	2 Recommended	Cost Estimate:	\$74,750.00
Implementation Priority:	3	Facility Function:	
Implementation Phase:		Implementation Date:	
Official Responsible:

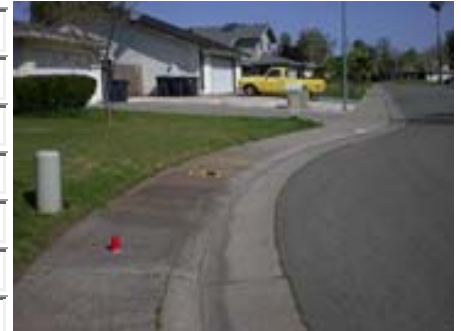
Barrier Type: Cross Slope - Existing (4.1% to 4.9%)

Description: Cross slope exceeds 2.0% (4.1% to 4.9%)

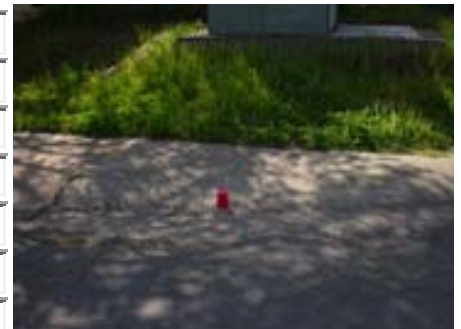
Barrier Type: No Curb Ramp - Depressed Existing Curb

Description: No compliant curb cut at corner (intersection)

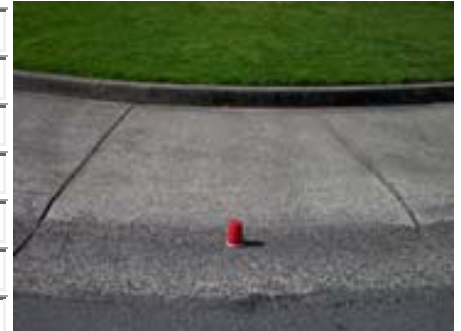
Barrier Type: No Curb Ramp - Depressed Existing Curb

Description: No compliant curb cut at corner (intersection)

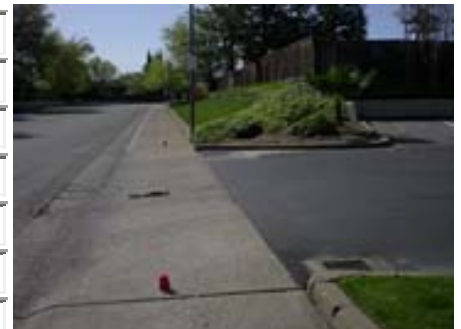
Barrier Type: Driveway - Existing (5.0% or more)

Description: Driveway cross slope exceeds 2.0% (5.0% or more)

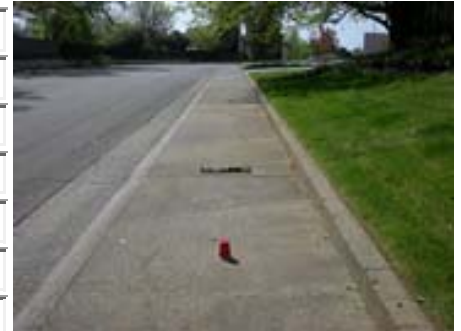
Field Date:	4/12/2011	Report Date:	4/12/2011	Barrier #:	6798
Location:	Crux Dr - West				
X Coordinate:	-121.26945				
Y Coordinate:	38.695				
Barrier Area:	Sidewalks				
Barrier Type:	Cross Slope - Existing (4.1% to 4.9%)				
Code Ref:	CBC 1133B.7.1.3 and ADA/ABA 403.3

As Built Meas:	101	Quantity:	LF
Description:	Cross slope exceeds 2.0% (4.1% to 4.9%)		
As Built Desc:	4.2% cross slope		
Solution:	Demolish existing and construct new route		
Bar. Severity:	2 Recommended	Cost Estimate:	\$12,625.00
Implementation Priority:	4	Facility Function:	
Implementation Phase:		Implementation Date:	
Official Responsible:			
Notes:

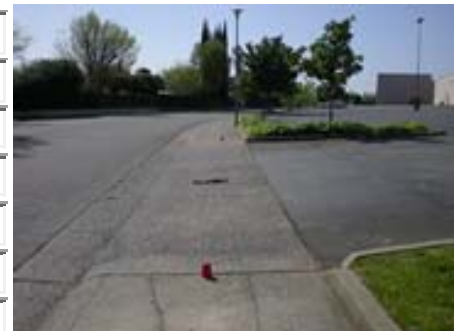
Field Date:	4/12/2011	Report Date:	4/12/2011	Barrier #:	6799
Location:	Crux Dr - West				
X Coordinate:	-121.26933				
Y Coordinate:	38.69473				
Barrier Area:	Sidewalks				
Barrier Type:	Driveway - Existing (5.0% or more)				
Code Ref:	CBC 1133B.7.1.3 and ADA/ABA 403.3

As Built Meas:	44	Quantity:	LF
Description:	Driveway cross slope exceeds 2.0% (5.0% or more)		
As Built Desc:	8.8% cross slope		
Solution:	Provide min. 48" wide level walkway through driveway		
Bar. Severity:	4 Low Severity	Cost Estimate:	\$5,500.00
Implementation Priority:	4	Facility Function:	
Implementation Phase:		Implementation Date:	
Official Responsible:			
Notes:

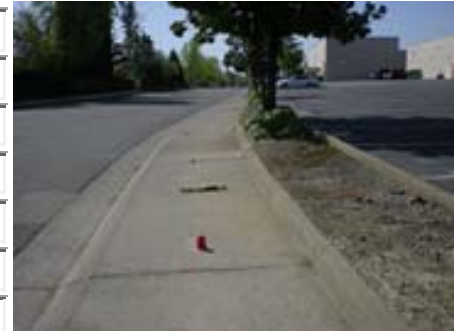
Field Date:	4/12/2011	Report Date:	4/12/2011	Barrier #:	6800
Location:	Crux Dr - West				
X Coordinate:	-121.26921				
Y Coordinate:	38.69436				
Barrier Area:	Sidewalks				
Barrier Type:	Cross Slope - Existing (4.1% to 4.9%)				
Code Ref:	CBC 1133B.7.1.3 and ADA/ABA 403.3

As Built Meas:	181	Quantity:	LF
Description:	Cross slope exceeds 2.0% (4.1% to 4.9%)		
As Built Desc:	4.2% cross slope		
Solution:	Demolish existing and construct new route		
Bar. Severity:	2 Recommended	Cost Estimate:	\$22,625.00
Implementation Priority:	4	Facility Function:	
Implementation Phase:		Implementation Date:	
Official Responsible:

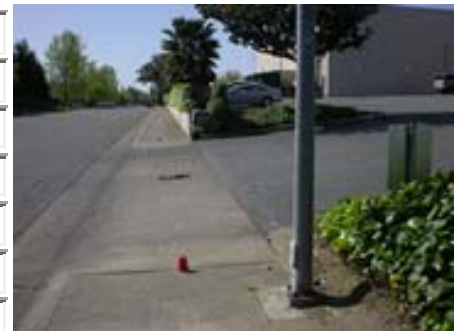
Field Date:	4/12/2011	Report Date:	4/12/2011	Barrier #:	6801
Location:	Crux Dr - West				
X Coordinate:	-121.26919				
Y Coordinate:	38.69384				
Barrier Area:	Sidewalks				
Barrier Type:	Driveway - Existing (5.0% or more)				
Code Ref:	CBC 1133B.7.1.3 and ADA/ABA 403.3

As Built Meas:	43	Quantity:	LF
Description:	Driveway cross slope exceeds 2.0% (5.0% or more)		
As Built Desc:	7.2% cross slope		
Solution:	Provide min. 48" wide level walkway through driveway		
Bar. Severity:	4 Low Severity	Cost Estimate:	\$5,375.00
Implementation Priority:	4	Facility Function:	
Implementation Phase:		Implementation Date:	
Official Responsible:

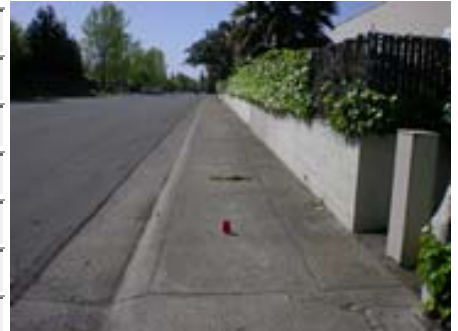
Field Date:	4/12/2011	Report Date:	4/12/2011	Barrier #:	6802
Location:	Crux Dr - West				
X Coordinate:	-121.2692				
Y Coordinate:	38.69373				
Barrier Area:	Sidewalks				
Barrier Type:	Cross Slope - Existing (4.1% to 4.9%)				
Code Ref:	CBC 1133B.7.1.3 and ADA/ABA 403.3

As Built Meas:	513	Quantity:	LF
Description:	Cross slope exceeds 2.0% (4.1% to 4.9%)		
As Built Desc:	4.6% cross slope		
Solution:	Demolish existing and construct new route		
Bar. Severity:	2 Recommended	Cost Estimate:	\$64,125.00
Implementation Priority:	4	Facility Function:	
Implementation Phase:		Implementation Date:	
Official Responsible:

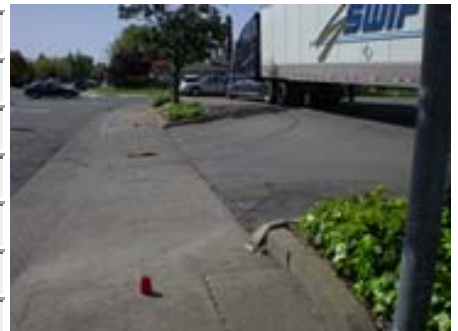
Field Date:	4/12/2011	Report Date:	4/12/2011	Barrier #:	6803
Location:	Crux Dr - West				
X Coordinate:	-121.26917				
Y Coordinate:	38.6923				
Barrier Area:	Sidewalks				
Barrier Type:	Driveway - Existing (5.0% or more)				
Code Ref:	CBC 1133B.7.1.3 and ADA/ABA 403.3

As Built Meas:	44	Quantity:	LF
Description:	Driveway cross slope exceeds 2.0% (5.0% or more)		
As Built Desc:	6.3% cross slope		
Solution:	Provide min. 48" wide level walkway through driveway		
Bar. Severity:	4 Low Severity	Cost Estimate:	\$5,500.00
Implementation Priority:	4	Facility Function:	
Implementation Phase:		Implementation Date:	
Official Responsible:
