DRAFT ADA TRANSITION PLAN UPDATE
NEIGHBORHOOD AREA 9 SONA
SEPTEMBER 20, 2011

CITY OF CITRUS HEIGHTS

The Sunrise Oaks Neighborhood Association (SONA)

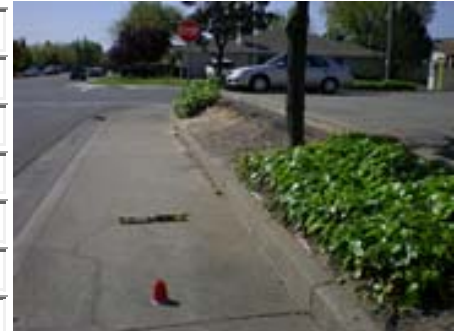
Field Date:	4/12/2011	Report Date:	4/12/2011	Barrier #:	6804
Location:	Crux Dr - West				
X Coordinate:	-121.26919				
Y Coordinate:	38.69225				
Barrier Area:	Sidewalks				
Barrier Type:	Cross Slope - Existing (4.1% to 4.9%)				
Code Ref:	CBC 1133B.7.1.3 and ADA/ABA 403.3

As Built Meas:	56	Quantity:	LF
Description:	Cross slope exceeds 2.0% (4.1% to 4.9%)		
As Built Desc:	4.5% cross slope		
Solution:	Demolish existing and construct new route		
Bar. Severity:	2 Recommended	Cost Estimate:	\$7,000.00
Implementation Priority:	4	Facility Function:	
Implementation Phase:		Implementation Date:	
Official Responsible:			
Notes:

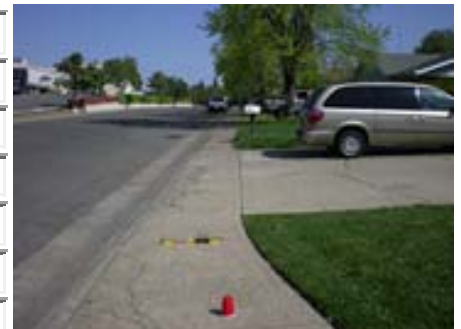
Field Date:	4/12/2011	Report Date:	4/12/2011	Barrier #:	6805A
Location:	Crux Dr - East				
X Coordinate:	-121.26898				
Y Coordinate:	38.69215				
Barrier Area:	Sidewalks				
Barrier Type:	Cross Slope - Existing (5.0% or more)				
Code Ref:	CBC 1133B.7.1.3 and ADA/ABA 403.3

As Built Meas:	337	Quantity:	LF
Description:	Cross slope exceeds 2.0% (5.0% or more)		
As Built Desc:	5.1% cross slope		
Solution:	Demolish existing and construct new route		
Bar. Severity:	1 Necessary	Cost Estimate:	\$42,125.00
Implementation Priority:	4	Facility Function:	
Implementation Phase:		Implementation Date:	
Official Responsible:			
Notes:

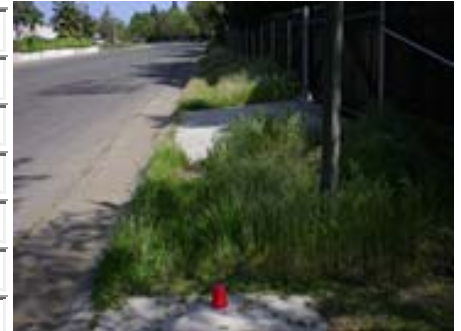
Field Date:	4/12/2011	Report Date:	4/12/2011	Barrier #:	6805B
Location:	Crux Dr - East				
X Coordinate:	-121.26898				
Y Coordinate:	38.69302				
Barrier Area:	Sidewalks				
Barrier Type:	No Sidewalk - No Barricade				
Code Ref:	MUTCD Section 6D.01

As Built Meas:	1	Quantity:	JOB
Description:	No barricade provided where sidewalk ends in hazardous location		
As Built Desc:	No barricade or other warning provided for the visually impaired at end of sidewalk		
Solution:	Provide barricade with cane detectable warning at end of sidewalk		
Bar. Severity:	1 Necessary	Cost Estimate:	\$1,350.00
Implementation Priority:	4	Facility Function:	
Implementation Phase:		Implementation Date:	
Official Responsible:			
Notes:

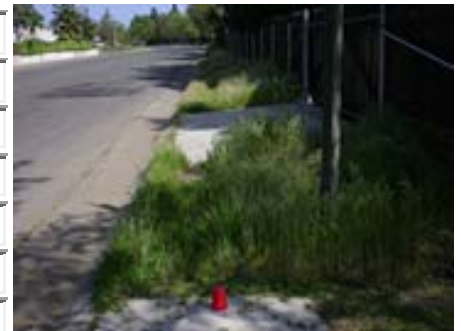
Field Date:	4/12/2011	Report Date:	4/12/2011	Barrier #:	6806
Location:	Crux Dr - East				
X Coordinate:	-121.26897				
Y Coordinate:	38.6931				
Barrier Area:	Sidewalks				
Barrier Type:	No sidewalk				
Code Ref:	CBC 1127B.1 and ADA/ABA 206.2.1

As Built Meas:	926	Quantity:	LF
Description:	No pedestrian route provided		
As Built Desc:	No sidewalk provided		
Solution:	Construct new firm and stable pedestrian route		
Bar. Severity:	1 Necessary	Cost Estimate:	\$92,600.00
Implementation Priority:	4	Facility Function:	
Implementation Phase:		Implementation Date:	
Official Responsible:			
Notes:

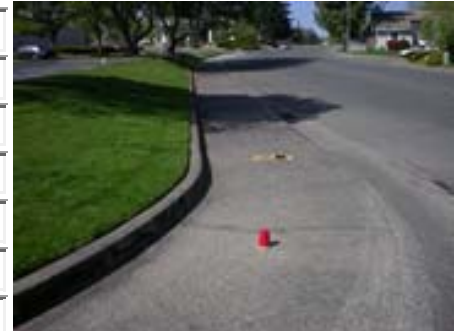
Barrier Type: Cross Slope - Existing (5.0% or more)

Description: Cross slope exceeds 2.0% (5.0% or more)

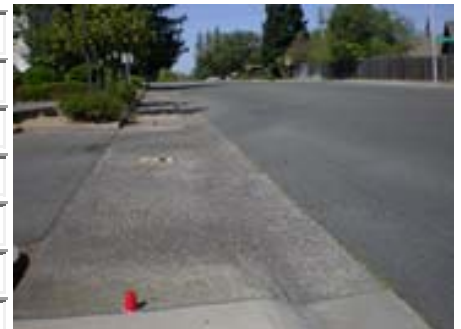
Barrier Type: Driveway - Existing (5.0% or more)

Description: Driveway cross slope exceeds 2.0% (5.0% or more)

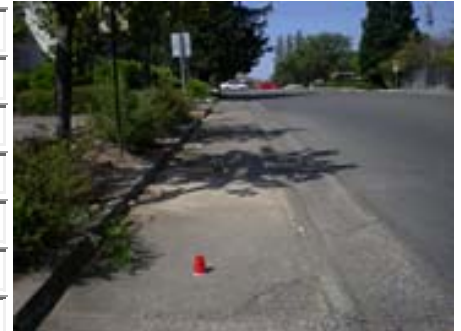
Field Date:	4/12/2011	Report Date:	4/12/2011	Barrier #:	6809
Location:	Sungarden Dr - South				
X Coordinate:	-121.27083				
Y Coordinate:	38.69534				
Barrier Area:	Sidewalks				
Barrier Type:	Cross Slope - Existing (4.1% to 4.9%)				
Code Ref:	CBC 1133B.7.1.3 and ADA/ABA 403.3

As Built Meas:	71	Quantity:	LF
Description:	Cross slope exceeds 2.0% (4.1% to 4.9%)		
As Built Desc:	4.3% cross slope		
Solution:	Demolish existing and construct new route		
Bar. Severity:	2 Recommended	Cost Estimate:	\$8,875.00
Implementation Priority:	4	Facility Function:	
Implementation Phase:		Implementation Date:	
Official Responsible:

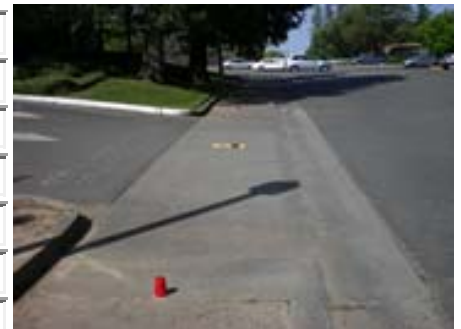
Field Date:	4/12/2011	Report Date:	4/12/2011	Barrier #:	6810
Location:	Sungarden Dr - South				
X Coordinate:	-121.27113				
Y Coordinate:	38.69536				
Barrier Area:	Sidewalks				
Barrier Type:	Driveway - Existing (5.0% or more)				
Code Ref:	CBC 1133B.7.1.3 and ADA/ABA 403.3

As Built Meas:	38	Quantity:	LF
Description:	Driveway cross slope exceeds 2.0% (5.0% or more)		
As Built Desc:	6.5% cross slope		
Solution:	Provide min. 48" wide level walkway through driveway		
Bar. Severity:	4 Low Severity	Cost Estimate:	\$4,750.00
Implementation Priority:	4	Facility Function:	
Implementation Phase:		Implementation Date:	
Official Responsible:

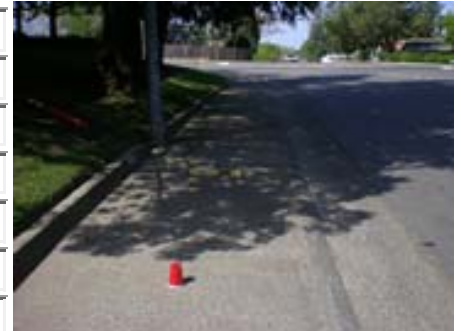
Field Date:	4/12/2011	Report Date:	4/12/2011	Barrier #:	6811
Location:	Sungarden Dr - South				
X Coordinate:	-121.27122				
Y Coordinate:	38.69537				
Barrier Area:	Sidewalks				
Barrier Type:	Cross Slope - Existing (4.1% to 4.9%)				
Code Ref:	CBC 1133B.7.1.3 and ADA/ABA 403.3

As Built Meas:	90	Quantity:	LF
Description:	Cross slope exceeds 2.0% (4.1% to 4.9%)		
As Built Desc:	4.4% cross slope		
Solution:	Demolish existing and construct new route		
Bar. Severity:	2 Recommended	Cost Estimate:	\$11,250.00
Implementation Priority:	4	Facility Function:	
Implementation Phase:		Implementation Date:	
Official Responsible:

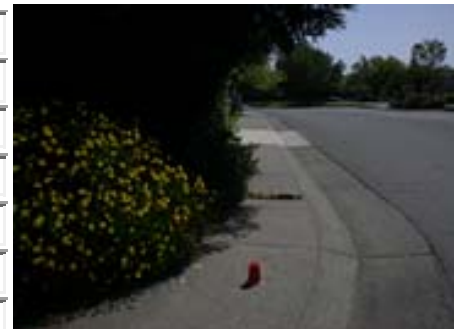
Field Date:	4/12/2011	Report Date:	4/12/2011	Barrier #:	6812
Location:	Sungarden Dr - North				
X Coordinate:	-121.27158				
Y Coordinate:	38.69547				
Barrier Area:	Sidewalks				
Barrier Type:	Cross Slope - Existing (5.0% or more)				
Code Ref:	CBC 1133B.7.1.3 and ADA/ABA 403.3

As Built Meas:	162	Quantity:	LF
Description:	Cross slope exceeds 2.0% (5.0% or more)		
As Built Desc:	5.2% cross slope		
Solution:	Demolish existing and construct new route		
Bar. Severity:	1 Necessary	Cost Estimate:	\$20,250.00
Implementation Priority:	4	Facility Function:	
Implementation Phase:		Implementation Date:	
Official Responsible:

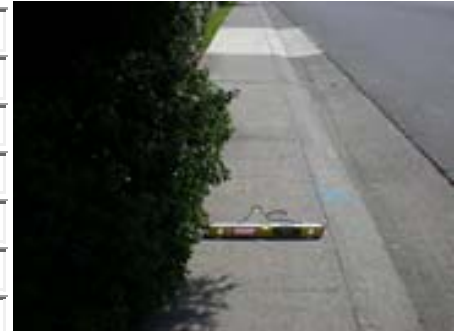
Barrier Type: Clear Width - Existing ($\leq 31"$ or less)

Description: Pedestrian route is not min. 48" wide ($\leq 31"$ or less)

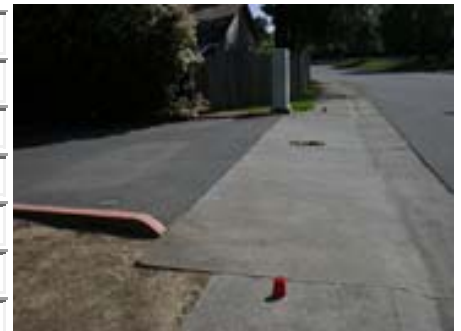
Barrier Type: Driveway - Existing (5.0% or more)

Description: Driveway cross slope exceeds 2.0% (5.0% or more)

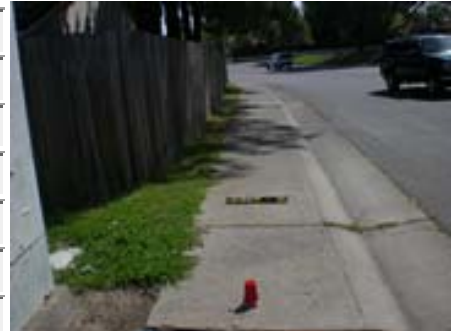
Field Date:	4/12/2011	Report Date:	4/12/2011	Barrier #:	6815
Location:	Sungarden Dr - North				
X Coordinate:	-121.2708				
Y Coordinate:	38.69549				
Barrier Area:	Sidewalks				
Barrier Type:	Cross Slope - Existing (5.0% or more)				
Code Ref:	CBC 1133B.7.1.3 and ADA/ABA 403.3

As Built Meas:	103	Quantity:	LF
Description:	Cross slope exceeds 2.0% (5.0% or more)		
As Built Desc:	6.0% cross slope		
Solution:	Demolish existing and construct new route		
Bar. Severity:	1 Necessary	Cost Estimate:	\$12,875.00
Implementation Priority:	4	Facility Function:	
Implementation Phase:		Implementation Date:	
Official Responsible:

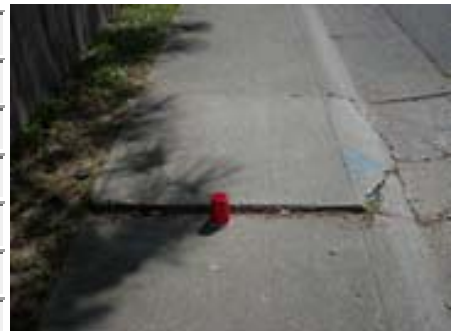
Field Date:	4/12/2011	Report Date:	4/12/2011	Barrier #:	6816
Location:	Sungarden Dr - North				
X Coordinate:	-121.27069				
Y Coordinate:	38.69546				
Barrier Area:	Sidewalks				
Barrier Type:	Abrupt Change in Level - > 1/2"				
Code Ref:	CBC 1133B.7.1 and ADA/ABA 303.3

As Built Meas:	4	Quantity:	LF
Description:	Change in level greater than 1/2"		
As Built Desc:	1/2" lip in sidewalk surface		
Solution:	Grind or repair sidewalk to remove trip hazard		
Bar. Severity:	1 Necessary	Cost Estimate:	\$1,000.00
Implementation Priority:	4	Facility Function:	
Implementation Phase:		Implementation Date:	
Official Responsible:

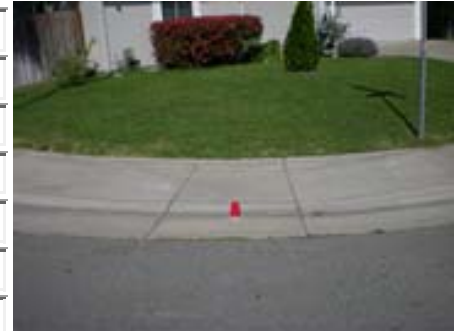
Field Date:	4/12/2011	Report Date:	4/12/2011	Barrier #:	6817A
Location:	Sungarden Dr and Crail Ct - Corner A				
X Coordinate:	-121.27044				
Y Coordinate:	38.69553				
Barrier Area:	Curb Ramps				
Barrier Type:	Perpendicular Ramp Landing (4.1% to 4.9%)				
Code Ref:	CBC 1127B.5.4 and ADA/ABA 406.4

As Built Meas:	1	Quantity:	EACH
Description:	Curb ramp top landing not level (4.1% to 4.9%)		
As Built Desc:	4.2% landing slope		
Solution:	Demolish existing and construct new transition		
Bar. Severity:	1 Necessary	Cost Estimate:	\$250.00
Implementation Priority:	4	Facility Function:	
Implementation Phase:		Implementation Date:	
Official Responsible:

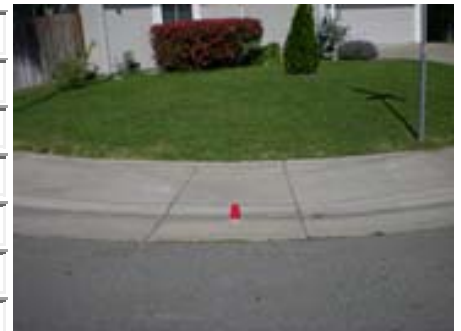
Field Date:	4/12/2011	Report Date:	4/12/2011	Barrier #:	6817B
Location:	Sungarden Dr and Crail Ct - Corner A				
X Coordinate:	-121.27044				
Y Coordinate:	38.69553				
Barrier Area:	Curb Ramps				
Barrier Type:	Detectable Warnings - Truncated Domes				
Code Ref:	CBC 1127B.5.7 and ADA/ABA 705.1.3

As Built Meas:	1	Quantity:	EACH
Description:	No truncated domes provided at curb ramp		
As Built Desc:	No detectable warnings at curb ramp		
Solution:	Provide compliant truncated domes		
Bar. Severity:	2 Recommended	Cost Estimate:	\$1,400.00
Implementation Priority:	4	Facility Function:	
Implementation Phase:		Implementation Date:	
Official Responsible:

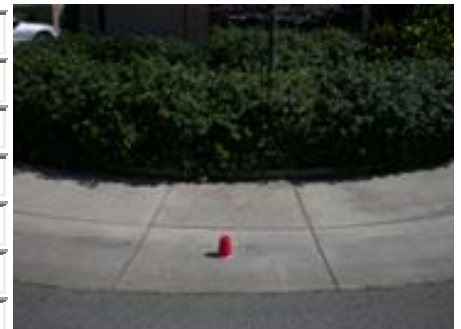
Field Date:	4/12/2011	Report Date:	4/12/2011	Barrier #:	6818A
Location:	Sungarden Dr and Crail Ct - Corner B				
X Coordinate:	-121.27024				
Y Coordinate:	38.69553				
Barrier Area:	Curb Ramps				
Barrier Type:	12" Grooves - Existing (3.1% to 4.0%)				
Code Ref:	CBC 1127B.5.6

As Built Meas:	1	Quantity:	EACH
Description:	12" grooves at top of curb ramp are not level (3.1% to 4.0%)		
As Built Desc:	3.3% at 12" grooves		
Solution:	Demolish existing and construct new curb ramp		
Bar. Severity:	3 Hindrance	Cost Estimate:	\$2,500.00
Implementation Priority:	4	Facility Function:	
Implementation Phase:		Implementation Date:	
Official Responsible:

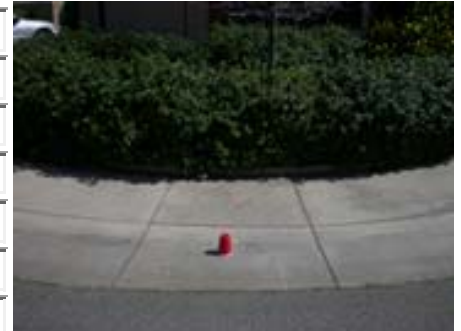
Field Date:	4/12/2011	Report Date:	4/12/2011	Barrier #:	6818B
Location:	Sungarden Dr and Crail Ct - Corner B				
X Coordinate:	-121.27024				
Y Coordinate:	38.69553				
Barrier Area:	Curb Ramps				
Barrier Type:	Detectable Warnings - Truncated Domes				
Code Ref:	CBC 1127B.5.7 and ADA/ABA 705.1.3

As Built Meas:	1	Quantity:	EACH
Description:	No truncated domes provided at curb ramp		
As Built Desc:	No detectable warnings at curb ramp		
Solution:	Provide compliant truncated domes		
Bar. Severity:	2 Recommended	Cost Estimate:	\$0.00
Implementation Priority:	4	Facility Function:	
Implementation Phase:		Implementation Date:	
Official Responsible:

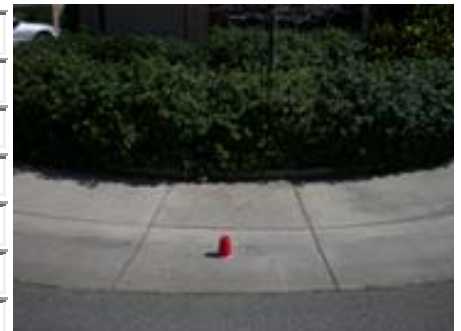
Field Date:	4/12/2011	Report Date:	4/12/2011	Barrier #:	6818C
Location:	Sungarden Dr and Crail Ct - Corner B				
X Coordinate:	-121.27024				
Y Coordinate:	38.69553				
Barrier Area:	Curb Ramps				
Barrier Type:	Gutter Slope - Existing (6.6% to 8.2%)				
Code Ref:	CBC 1127B.5.3 and ADA/ABA 406.2

As Built Meas:	1	Quantity:	SF
Description:	Gutter slope exceeds 5.0% (6.6% to 8.2%)		
As Built Desc:	7.3% gutter slope		
Solution:	Demolish existing and construct new gutter		
Bar. Severity:	2 Recommended	Cost Estimate:	\$0.00
Implementation Priority:	4	Facility Function:	
Implementation Phase:		Implementation Date:	
Official Responsible:

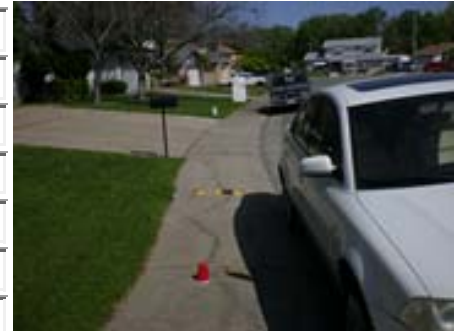
Field Date:	4/12/2011	Report Date:	4/12/2011	Barrier #:	6819
Location:	Crail Ct - West				
X Coordinate:	-121.27044				
Y Coordinate:	38.69561				
Barrier Area:	Sidewalks				
Barrier Type:	Cross Slope - Existing (5.0% or more)				
Code Ref:	CBC 1133B.7.1.3 and ADA/ABA 403.3

As Built Meas:	356	Quantity:	LF
Description:	Cross slope exceeds 2.0% (5.0% or more)		
As Built Desc:	6.1% cross slope		
Solution:	Demolish existing and construct new route		
Bar. Severity:	1 Necessary	Cost Estimate:	\$44,500.00
Implementation Priority:	4	Facility Function:	
Implementation Phase:		Implementation Date:	
Official Responsible:			
Notes:

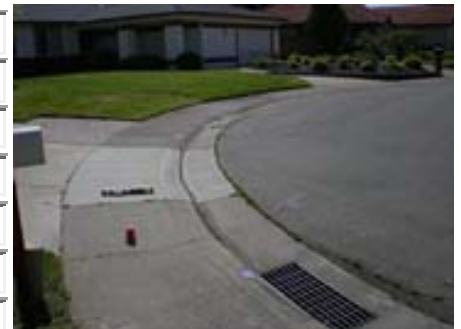
Field Date:	4/12/2011	Report Date:	4/12/2011	Barrier #:	6820
Location:	Crail Ct - East				
X Coordinate:	-121.27022				
Y Coordinate:	38.69626				
Barrier Area:	Sidewalks				
Barrier Type:	Cross Slope - Existing (5.0% or more)				
Code Ref:	CBC 1133B.7.1.3 and ADA/ABA 403.3

As Built Meas:	346	Quantity:	LF
Description:	Cross slope exceeds 2.0% (5.0% or more)		
As Built Desc:	7.0% cross slope		
Solution:	Demolish existing and construct new route		
Bar. Severity:	1 Necessary	Cost Estimate:	\$43,250.00
Implementation Priority:	4	Facility Function:	
Implementation Phase:		Implementation Date:	
Official Responsible:			
Notes:

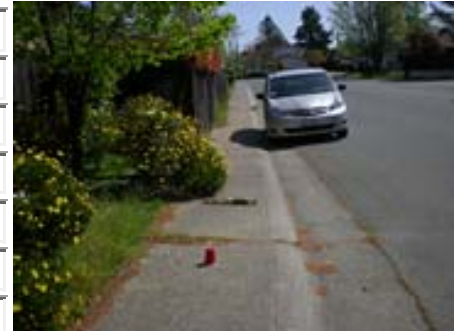
Field Date:	4/12/2011	Report Date:	4/12/2011	Barrier #:	6821A
Location:	Sungarden Dr - North				
X Coordinate:	-121.27004				
Y Coordinate:	38.69559				
Barrier Area:	Sidewalks				
Barrier Type:	Cross Slope - Existing (5.0% or more)				
Code Ref:	CBC 1133B.7.1.3 and ADA/ABA 403.3

As Built Meas:	257	Quantity:	LF
Description:	Cross slope exceeds 2.0% (5.0% or more)		
As Built Desc:	6.0% cross slope		
Solution:	Demolish existing and construct new route		
Bar. Severity:	1 Necessary	Cost Estimate:	\$32,125.00
Implementation Priority:	4	Facility Function:	
Implementation Phase:		Implementation Date:	
Official Responsible:			
Notes:

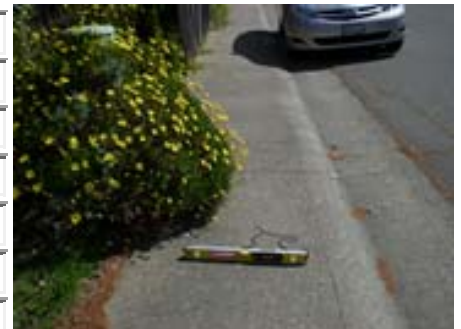
Field Date:	4/12/2011	Report Date:	4/12/2011	Barrier #:	6821B
Location:	Sungarden Dr - North				
X Coordinate:	-121.26993				
Y Coordinate:	38.69561				
Barrier Area:	Sidewalks				
Barrier Type:	Clear Width - Existing ($\leq 31"$ or less)				
Code Ref:	CBC 1133B.7.1

As Built Meas:	1	Quantity:	LF
Description:	Pedestrian route is not min. 48" wide ($\leq 31"$ or less)		
As Built Desc:	24" clear width due to foliage		
Solution:	Trim foliage to provide min. 48" clear width		
Bar. Severity:	1 Necessary	Cost Estimate:	\$125.00
Implementation Priority:	4	Facility Function:	
Implementation Phase:		Implementation Date:	
Official Responsible:			
Notes:

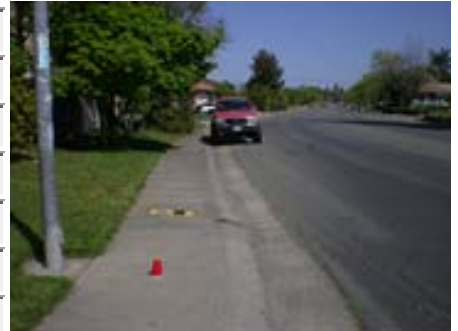
Field Date:	4/12/2011	Report Date:	4/12/2011	Barrier #:	6822A
Location:	Canelo Hills Dr - West				
X Coordinate:	-121.26932				
Y Coordinate:	38.69585				
Barrier Area:	Sidewalks				
Barrier Type:	Cross Slope - Existing (5.0% or more)				
Code Ref:	CBC 1133B.7.1.3 and ADA/ABA 403.3

As Built Meas:	344	Quantity:	LF
Description:	Cross slope exceeds 2.0% (5.0% or more)		
As Built Desc:	6.4% cross slope		
Solution:	Demolish existing and construct new route		
Bar. Severity:	1 Necessary	Cost Estimate:	\$43,000.00
Implementation Priority:	3	Facility Function:	
Implementation Phase:		Implementation Date:	
Official Responsible:

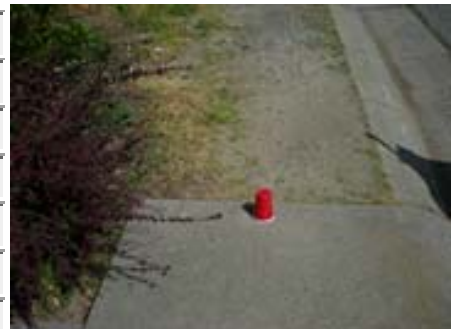
Field Date:	4/12/2011	Report Date:	4/12/2011	Barrier #:	6822B
Location:	Canelo Hills Dr - West				
X Coordinate:	-121.26947				
Y Coordinate:	38.69675				
Barrier Area:	Sidewalks				
Barrier Type:	No Sidewalk - No Barricade				
Code Ref:	MUTCD Section 6D.01

As Built Meas:	1	Quantity:	JOB
Description:	No barricade provided where sidewalk ends in hazardous location		
As Built Desc:	No barricade or other warning provided for the visually impaired at end of sidewalk		
Solution:	Provide barricade with cane detectable warning at end of sidewalk		
Bar. Severity:	1 Necessary	Cost Estimate:	\$1,350.00
Implementation Priority:	3	Facility Function:	
Implementation Phase:		Implementation Date:	
Official Responsible:

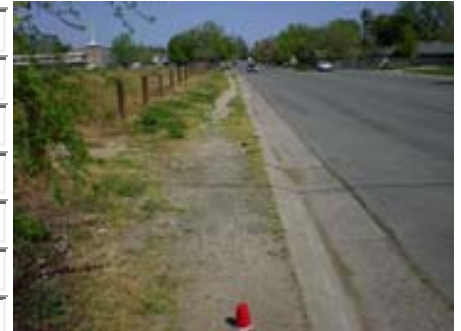
Field Date:	4/12/2011	Report Date:	4/12/2011	Barrier #:	6823
Location:	Canelo Hills Dr - West				
X Coordinate:	-121.26945				
Y Coordinate:	38.69676				
Barrier Area:	Sidewalks				
Barrier Type:	No sidewalk				
Code Ref:	CBC 1127B.1 and ADA/ABA 206.2.1

As Built Meas:	219	Quantity:	LF
Description:	No pedestrian route provided		
As Built Desc:	No sidewalk provided		
Solution:	Construct new firm and stable pedestrian route		
Bar. Severity:	1 Necessary	Cost Estimate:	\$21,900.00
Implementation Priority:	3	Facility Function:	
Implementation Phase:		Implementation Date:	
Official Responsible:

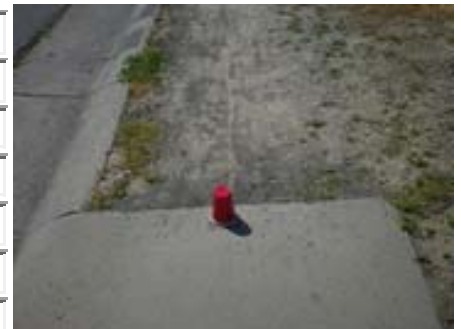
Field Date:	4/12/2011	Report Date:	4/12/2011	Barrier #:	6824
Location:	Canelo Hills Dr - West				
X Coordinate:	-121.26945				
Y Coordinate:	38.69737				
Barrier Area:	Sidewalks				
Barrier Type:	No Sidewalk - No Barricade				
Code Ref:	MUTCD Section 6D.01

As Built Meas:	1	Quantity:	JOB
Description:	No barricade provided where sidewalk ends in hazardous location		
As Built Desc:	No barricade or other warning provided for the visually impaired at end of sidewalk		
Solution:	Provide barricade with cane detectable warning at end of sidewalk		
Bar. Severity:	1 Necessary	Cost Estimate:	\$1,350.00
Implementation Priority:	3	Facility Function:	
Implementation Phase:		Implementation Date:	
Official Responsible:

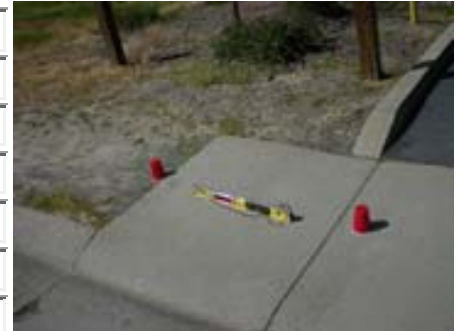
Field Date:	4/12/2011	Report Date:	4/12/2011	Barrier #:	6825
Location:	Canelo Hills Dr - West				
X Coordinate:	-121.26944				
Y Coordinate:	38.69735				
Barrier Area:	Sidewalks				
Barrier Type:	Driveway Running Slope - Existing (9.5% or more)				
Code Ref:	CBC 1133B.7.1.3 and ADA/ABA 403.3

As Built Meas:	4	Quantity:	LF
Description:	Running slope exceeds 8.3% (9.5% or more)		
As Built Desc:	11.4% running slope		
Solution:	Demolish existing and construct new pedestrian route		
Bar. Severity:	1 Necessary	Cost Estimate:	\$500.00
Implementation Priority:	3	Facility Function:	
Implementation Phase:		Implementation Date:	
Official Responsible:			
Notes:

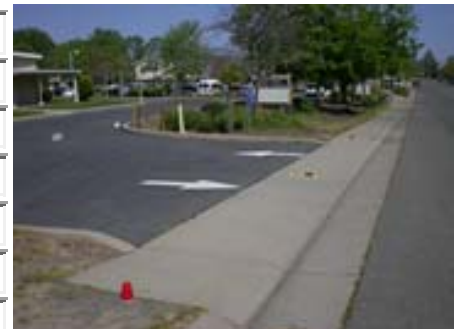
Field Date:	4/12/2011	Report Date:	4/12/2011	Barrier #:	6826
Location:	Canelo Hills Dr - West				
X Coordinate:	-121.26945				
Y Coordinate:	38.69745				
Barrier Area:	Sidewalks				
Barrier Type:	Driveway - Existing (3.1% to 4.0%)				
Code Ref:	CBC 1133B.7.1.3 and ADA/ABA 403.3

As Built Meas:	38	Quantity:	LF
Description:	Driveway cross slope exceeds 2.0% (3.1% to 4.0%)		
As Built Desc:	3.3% cross slope		
Solution:	Provide min. 48" wide level walkway through driveway		
Bar. Severity:	2 Recommended	Cost Estimate:	\$4,750.00
Implementation Priority:	3	Facility Function:	
Implementation Phase:		Implementation Date:	
Official Responsible:			
Notes:

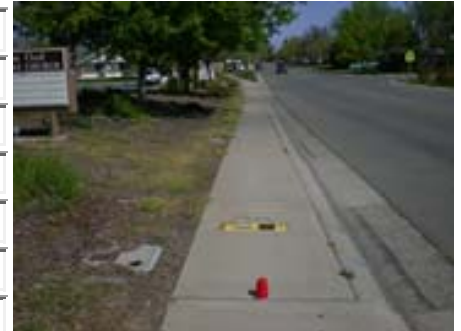
Barrier Type: Cross Slope - Existing (3.1% to 4.0%)

Code Ref: CBC 1133B.7.1.3 and ADA/ABA 403.3

As Built Meas: 137 Quantity: LF

Description: Cross slope exceeds 2.0% (3.1% to 4.0%)

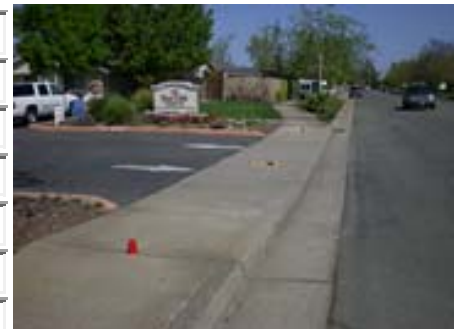
Barrier Type: Driveway - Existing (3.1% to 4.0%)

Code Ref: CBC 1133B.7.1.3 and ADA/ABA 403.3

As Built Meas: 46 Quantity: LF

Description: Driveway cross slope exceeds 2.0% (3.1% to 4.0%)

Bar. Severity: 2 Recommended Cost Estimate: \$5,750.00 Status:

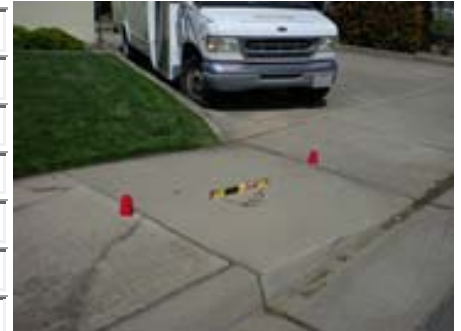
Field Date:	4/12/2011	Report Date:	4/12/2011	Barrier #:	6829
Location:	Canelo Hills Dr - West				
X Coordinate:	-121.2695				
Y Coordinate:	38.69838				
Barrier Area:	Sidewalks				
Barrier Type:	Driveway Running Slope - Existing (8.34% to 8.5%)				
Code Ref:	CBC 1133B.7.1.3 and ADA/ABA 403.3

As Built Meas:	5	Quantity:	LF
Description:	Running slope exceeds 8.3% (8.34% to 8.5%)		
As Built Desc:	8.4% running slope		
Solution:	Low severity barrier - no remediation recommended		
Bar. Severity:	4 Low Severity	Cost Estimate:	\$0.00
Implementation Priority:	3	Facility Function:	
Implementation Phase:		Implementation Date:	
Official Responsible:

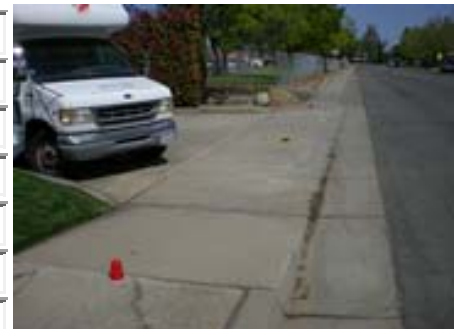
Field Date:	4/12/2011	Report Date:	4/12/2011	Barrier #:	6830
Location:	Canelo Hills Dr - West				
X Coordinate:	-121.26948				
Y Coordinate:	38.69849				
Barrier Area:	Sidewalks				
Barrier Type:	Driveway - Existing (3.1% to 4.0%)				
Code Ref:	CBC 1133B.7.1.3 and ADA/ABA 403.3

As Built Meas:	44	Quantity:	LF
Description:	Driveway cross slope exceeds 2.0% (3.1% to 4.0%)		
As Built Desc:	3.7% cross slope		
Solution:	Provide min. 48" wide level walkway through driveway		
Bar. Severity:	2 Recommended	Cost Estimate:	\$5,500.00
Implementation Priority:	3	Facility Function:	
Implementation Phase:		Implementation Date:	
Official Responsible:

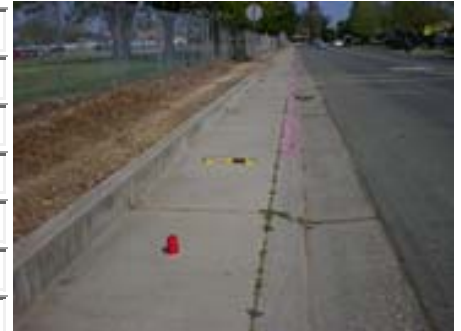
Field Date:	4/12/2011	Report Date:	4/12/2011	Barrier #:	6831
Location:	Canelo Hills Dr - West				
X Coordinate:	-121.26949				
Y Coordinate:	38.69875				
Barrier Area:	Sidewalks				
Barrier Type:	Cross Slope - Existing (3.1% to 4.0%)				
Code Ref:	CBC 1133B.7.1.3 and ADA/ABA 403.3

As Built Meas:	44	Quantity:	LF
Description:	Cross slope exceeds 2.0% (3.1% to 4.0%)		
As Built Desc:	3.2% cross slope		
Solution:	Demolish existing and construct new route		
Bar. Severity:	3 Hindrance	Cost Estimate:	\$5,500.00
Implementation Priority:	3	Facility Function:	
Implementation Phase:		Implementation Date:	
Official Responsible:

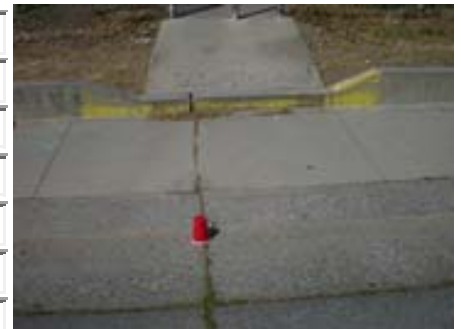
Field Date:	4/12/2011	Report Date:	4/12/2011	Barrier #:	6832
Location:	Canelo Hills Dr and Elementary School Entrance - Corner A				
X Coordinate:	-121.26947				
Y Coordinate:	38.69946				
Barrier Area:	Curb Ramps				
Barrier Type:	No Curb Ramp				
Code Ref:	CBC 1127B.5.1 and ADA/ABA 402.2

As Built Meas:	1	Quantity:	EACH
Description:	No curb cut at corner (intersection)		
As Built Desc:	No curb ramp at corner		
Solution:	Demolish existing and construct curb cut		
Bar. Severity:	1 Necessary	Cost Estimate:	\$2,500.00
Implementation Priority:	3	Facility Function:	
Implementation Phase:		Implementation Date:	
Official Responsible:

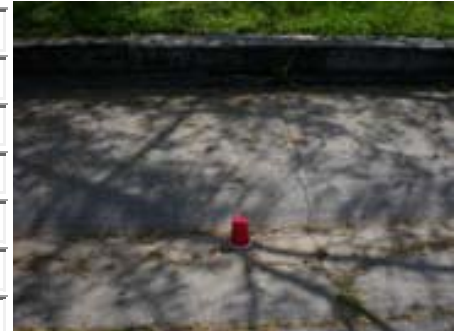
Field Date:	4/12/2011	Report Date:	4/12/2011	Barrier #:	6833
Location:	Canelo Hills Dr and Elementary School Entrance - Corner B				
X Coordinate:	-121.26922				
Y Coordinate:	38.69944				
Barrier Area:	Curb Ramps				
Barrier Type:	No Curb Ramp				
Code Ref:	CBC 1127B.5.1 and ADA/ABA 402.2

As Built Meas:	1	Quantity:	EACH
Description:	No curb cut at corner (intersection)		
As Built Desc:	No curb ramp at corner		
Solution:	Demolish existing and construct curb cut		
Bar. Severity:	1 Necessary	Cost Estimate:	\$2,500.00
Implementation Priority:	3	Facility Function:	
Implementation Phase:		Implementation Date:	
Official Responsible:			
Notes:	Two - way intersection corners A,B

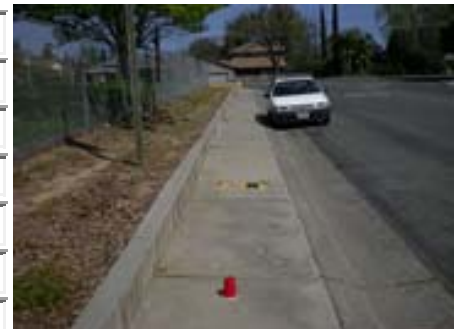
Field Date:	4/12/2011	Report Date:	4/12/2011	Barrier #:	6834
Location:	Canelo Hills Dr - West				
X Coordinate:	-121.26948				
Y Coordinate:	38.69995				
Barrier Area:	Sidewalks				
Barrier Type:	Cross Slope - Existing (5.0% or more)				
Code Ref:	CBC 1133B.7.1.3 and ADA/ABA 403.3

As Built Meas:	118	Quantity:	LF
Description:	Cross slope exceeds 2.0% (5.0% or more)		
As Built Desc:	6.6% cross slope		
Solution:	Demolish existing and construct new route		
Bar. Severity:	1 Necessary	Cost Estimate:	\$14,750.00
Implementation Priority:	3	Facility Function:	
Implementation Phase:		Implementation Date:	
Official Responsible:			
Notes:

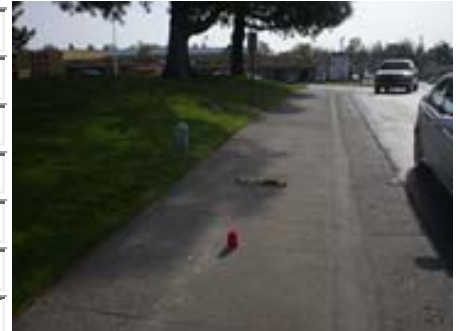
Field Date:	4/14/2011	Report Date:	4/14/2011	Barrier #:	6835
Location:	Woodmore Oaks Dr - North				
X Coordinate:	-121.2714				
Y Coordinate:	38.6922				
Barrier Area:	Sidewalks				
Barrier Type:	Cross Slope - Existing (2.1% to 3.0%)				
Code Ref:	CBC 1133B.7.1.3 and ADA/ABA 403.3

As Built Meas:	107	Quantity:	LF
Description:	Cross slope exceeds 2.0% (2.1% to 3.0%)		
As Built Desc:	2.7% cross slope		
Solution:	Low severity barrier - no remediation recommended		
Bar. Severity:	4 Low Severity	Cost Estimate:	\$0.00
Implementation Priority:	3	Facility Function:	
Implementation Phase:		Implementation Date:	
Official Responsible:

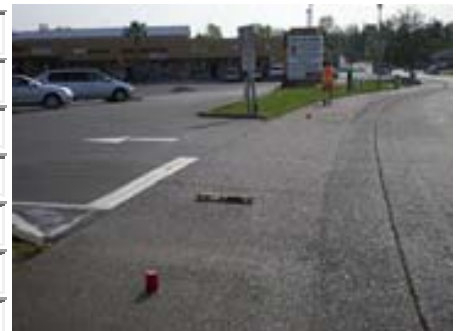
Field Date:	4/14/2011	Report Date:	4/14/2011	Barrier #:	6836
Location:	Woodmore Oaks Dr - North				
X Coordinate:	-121.27097				
Y Coordinate:	38.69219				
Barrier Area:	Sidewalks				
Barrier Type:	Driveway - Existing (5.0% or more)				
Code Ref:	CBC 1133B.7.1.3 and ADA/ABA 403.3

As Built Meas:	40	Quantity:	LF
Description:	Driveway cross slope exceeds 2.0% (5.0% or more)		
As Built Desc:	6.5% cross slope 11.1% running slope		
Solution:	Provide min. 48" wide level walkway through driveway		
Bar. Severity:	1 Necessary	Cost Estimate:	\$5,000.00
Implementation Priority:	3	Facility Function:	
Implementation Phase:		Implementation Date:	
Official Responsible:

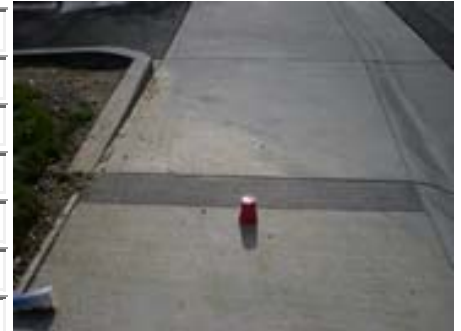
Barrier Type: Driveway -12" Grooves Incorrect Application

Code Ref: CBC 1127B.5.6

As Built Meas: 1 Quantity: JOB

Description: 12" grooves required only at curb ramps identified at transition into driveway

Solution: No remediation recommended, until new construction is performed in area

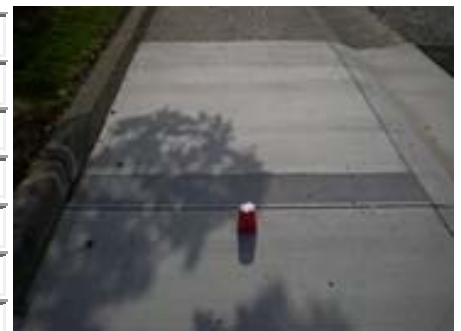
Barrier Type: Driveway -12" Grooves Incorrect Application

Code Ref: CBC 1127B.5.6

As Built Meas: 1 Quantity: JOB

Description: 12" grooves required only at curb ramps identified at transition into driveway

Solution: No remediation recommended, until new construction is performed in area

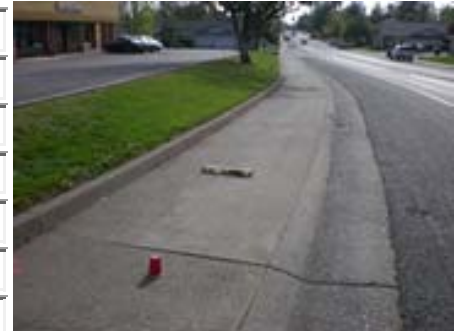
Field Date:	4/14/2011	Report Date:	4/14/2011	Barrier #:	6839
Location:	Woodmore Oaks Dr - North				
X Coordinate:	-121.26939				
Y Coordinate:	38.69204				
Barrier Area:	Sidewalks				
Barrier Type:	Cross Slope - Existing (3.1% to 4.0%)				
Code Ref:	CBC 1133B.7.1.3 and ADA/ABA 403.3

As Built Meas:	252	Quantity:	LF
Description:	Cross slope exceeds 2.0% (3.1% to 4.0%)		
As Built Desc:	4.0% cross slope		
Solution:	Demolish existing and construct new route		
Bar. Severity:	3 Hindrance	Cost Estimate:	\$31,500.00
Implementation Priority:	3	Facility Function:	
Implementation Phase:		Implementation Date:	
Official Responsible:

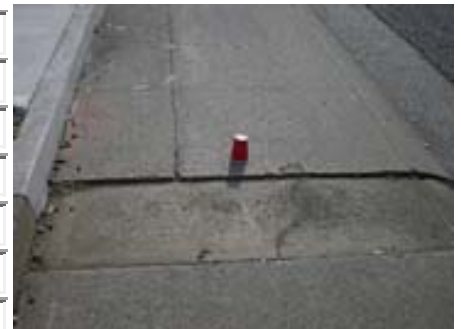
Field Date:	4/14/2011	Report Date:	4/14/2011	Barrier #:	6840
Location:	Woodmore Oaks Dr - North				
X Coordinate:	-121.26917				
Y Coordinate:	38.69203				
Barrier Area:	Sidewalks				
Barrier Type:	Abrupt Change in Level - > 1/2"				
Code Ref:	CBC 1133B.7.1 and ADA/ABA 303.3

As Built Meas:	4	Quantity:	LF
Description:	Change in level greater than 1/2"		
As Built Desc:	1/2" lip in sidewalk surface		
Solution:	Grind or repair sidewalk to remove trip hazard		
Bar. Severity:	1 Necessary	Cost Estimate:	\$1,000.00
Implementation Priority:	3	Facility Function:	
Implementation Phase:		Implementation Date:	
Official Responsible:

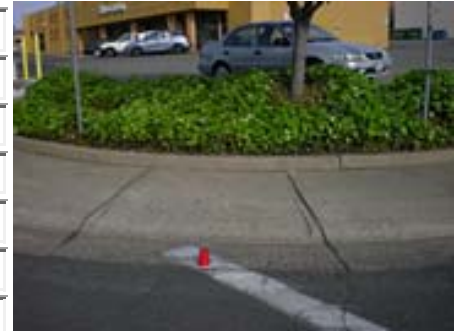
Field Date:	4/14/2011	Report Date:	4/14/2011	Barrier #:	6841
Location:	Woodmore Oaks Dr and Crux Dr - Corner A				
X Coordinate:	-121.26892				
Y Coordinate:	38.69203				
Barrier Area:	Curb Ramps				
Barrier Type:	No Curb Ramp - Depressed Existing Curb				
Code Ref:	CBC 1127B.5.1 and ADA/ABA 402.2

As Built Meas:	1	Quantity:	EACH
Description:	No compliant curb cut at corner (intersection)		
As Built Desc:	8.5% running slope at depressed area		
Solution:	Demolish existing and construct curb cut		
Bar. Severity:	1 Necessary	Cost Estimate:	\$2,500.00
Implementation Priority:	3	Facility Function:	
Implementation Phase:		Implementation Date:	
Official Responsible:			
Notes:	Four - way intersection corners A,B,C,D. Corners C,D compliant

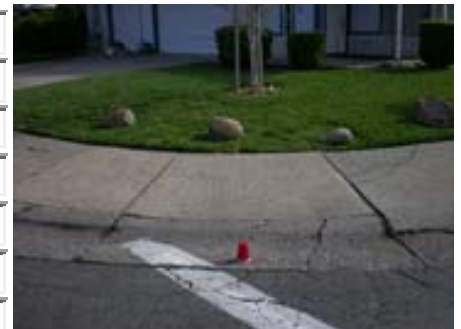
Field Date:	4/14/2011	Report Date:	4/14/2011	Barrier #:	6842
Location:	Woodmore Oaks Dr and Crux Dr - Corner B				
X Coordinate:	-121.26874				
Y Coordinate:	38.69207				
Barrier Area:	Curb Ramps				
Barrier Type:	No Curb Ramp - Depressed Existing Curb				
Code Ref:	CBC 1127B.5.1 and ADA/ABA 402.2

As Built Meas:	1	Quantity:	EACH
Description:	No compliant curb cut at corner (intersection)		
As Built Desc:	6.7% running slope at depressed area		
Solution:	Demolish existing and construct curb cut		
Bar. Severity:	1 Necessary	Cost Estimate:	\$2,500.00
Implementation Priority:	3	Facility Function:	
Implementation Phase:		Implementation Date:	
Official Responsible:			
Notes:	Four - way intersection corners A,B,C,D. Corners C,D compliant

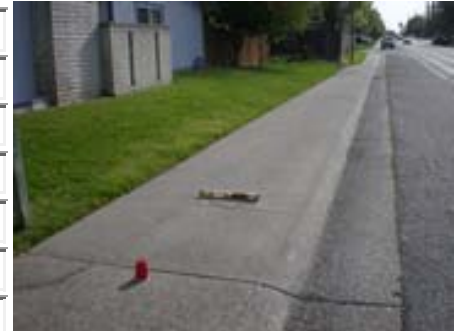
Field Date:	4/14/2011	Report Date:	4/14/2011	Barrier #:	6843
Location:	Woodmore Oaks Dr - North				
X Coordinate:	-121.26808				
Y Coordinate:	38.69206				
Barrier Area:	Sidewalks				
Barrier Type:	Cross Slope - Existing (3.1% to 4.0%)				
Code Ref:	CBC 1133B.7.1.3 and ADA/ABA 403.3

As Built Meas:	124	Quantity:	LF
Description:	Cross slope exceeds 2.0% (3.1% to 4.0%)		
As Built Desc:	3.2% cross slope		
Solution:	Demolish existing and construct new route		
Bar. Severity:	3 Hindrance	Cost Estimate:	\$15,500.00
Implementation Priority:	3	Facility Function:	
Implementation Phase:		Implementation Date:	
Official Responsible:

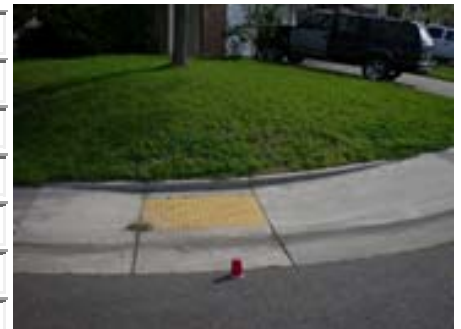
Field Date:	4/14/2011	Report Date:	4/14/2011	Barrier #:	6844
Location:	Woodmore Oaks Dr and Stone Canyon Cir - B				
X Coordinate:	-121.26449				
Y Coordinate:	38.69249				
Barrier Area:	Curb Ramps				
Barrier Type:	12" Grooves - Existing (4.1% to 4.9%)				
Code Ref:	CBC 1127B.5.6

As Built Meas:	1	Quantity:	EACH
Description:	12" grooves at top of curb ramp are not level (4.1% to 4.9%)		
As Built Desc:	4.5% at 12" grooves		
Solution:	Demolish existing and construct new curb ramp		
Bar. Severity:	2 Recommended	Cost Estimate:	\$2,500.00
Implementation Priority:	3	Facility Function:	
Implementation Phase:		Implementation Date:	
Official Responsible:

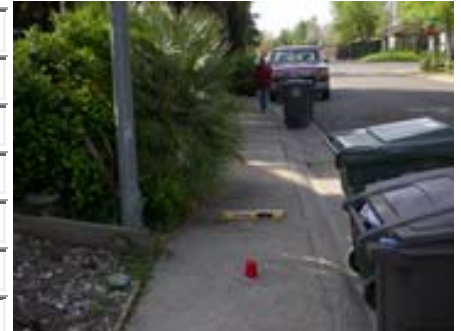
Field Date:	4/14/2011	Report Date:	4/14/2011	Barrier #:	6845A
Location:	Stone Canyon Cir - East				
X Coordinate:	-121.26448				
Y Coordinate:	38.69242				
Barrier Area:	Sidewalks				
Barrier Type:	Cross Slope - Existing (4.1% to 4.9%)				
Code Ref:	CBC 1133B.7.1.3 and ADA/ABA 403.3

As Built Meas:	104	Quantity:	LF
Description:	Cross slope exceeds 2.0% (4.1% to 4.9%)		
As Built Desc:	4.2% cross slope		
Solution:	Demolish existing and construct new route		
Bar. Severity:	2 Recommended	Cost Estimate:	\$13,000.00
Implementation Priority:	4	Facility Function:	
Implementation Phase:		Implementation Date:	
Official Responsible:			
Notes:

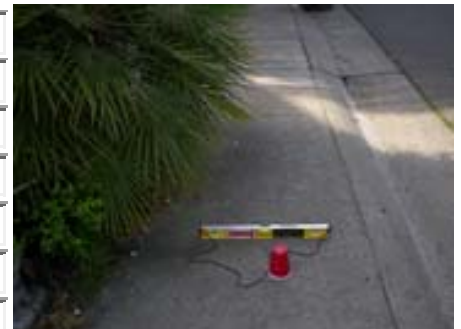
Field Date:	4/14/2011	Report Date:	4/14/2011	Barrier #:	6845B
Location:	Stone Canyon Cir - East				
X Coordinate:	-121.2645				
Y Coordinate:	38.69233				
Barrier Area:	Sidewalks				
Barrier Type:	Clear Width - Existing ($\leq 31"$ or less)				
Code Ref:	CBC 1133B.7.1

As Built Meas:	1	Quantity:	LF
Description:	Pedestrian route is not min. 48" wide ($\leq 31"$ or less)		
As Built Desc:	24" clear width due to foliage		
Solution:	Trim foliage to provide min. 48" clear width		
Bar. Severity:	1 Necessary	Cost Estimate:	\$125.00
Implementation Priority:	4	Facility Function:	
Implementation Phase:		Implementation Date:	
Official Responsible:			
Notes:

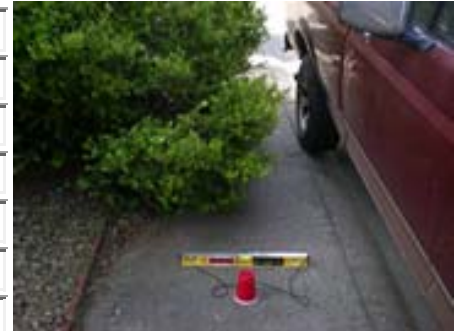
Field Date:	4/14/2011	Report Date:	4/14/2011	Barrier #:	6845C
Location:	Stone Canyon Cir - East				
X Coordinate:	-121.26463				
Y Coordinate:	38.69212				
Barrier Area:	Sidewalks				
Barrier Type:	Clear Width - Existing ($\leq 31"$ or less)				
Code Ref:	CBC 1133B.7.1

As Built Meas:	1	Quantity:	LF
Description:	Pedestrian route is not min. 48" wide ($\leq 31"$ or less)		
As Built Desc:	6" clear width due to foliage		
Solution:	Trim foliage to provide min. 48" clear width		
Bar. Severity:	1 Necessary	Cost Estimate:	\$125.00
Implementation Priority:	4	Facility Function:	
Implementation Phase:		Implementation Date:	
Official Responsible:			
Notes:

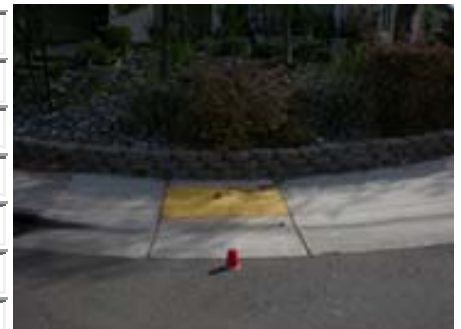
Field Date:	4/14/2011	Report Date:	4/14/2011	Barrier #:	6846A
Location:	Woodmore Oaks Dr and Stone Canyon Cir - B				
X Coordinate:	-121.26447				
Y Coordinate:	38.69212				
Barrier Area:	Curb Ramps				
Barrier Type:	12" Grooves - Existing (4.1% to 4.9%)				
Code Ref:	CBC 1127B.5.6

As Built Meas:	1	Quantity:	EACH
Description:	12" grooves at top of curb ramp are not level (4.1% to 4.9%)		
As Built Desc:	4.6% at 12" grooves		
Solution:	Demolish existing and construct new curb ramp		
Bar. Severity:	2 Recommended	Cost Estimate:	\$2,500.00
Implementation Priority:	3	Facility Function:	
Implementation Phase:		Implementation Date:	
Official Responsible:			
Notes:	Four - way intersection corners A,B,C,D. Corner A compliant

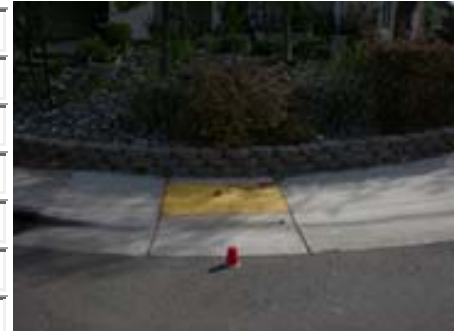
As Built Meas:	1	Quantity:	EACH
Description:	Curb ramp landing or pan not level(4.1% to 4.9%)		
As Built Desc:	4.4% landing slope		
Solution:	Demolish existing and construct new transition		
Bar. Severity:	2 Recommended	Cost Estimate:	\$0.00
Implementation Priority:	3	Facility Function:	
Implementation Phase:		Implementation Date:	
Official Responsible:			
Notes:	Four - way intersection corners A,B,C,D. Corner A compliant

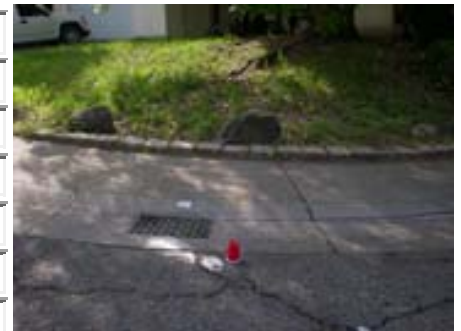
Field Date:	4/14/2011	Report Date:	4/14/2011	Barrier #:	6847
Location:	Woodmore Oaks Dr and Stone Canyon Cir - C				
X Coordinate:	-121.26445				
Y Coordinate:	38.69195				
Barrier Area:	Curb Ramps				
Barrier Type:	No Curb Ramp				
Code Ref:	CBC 1127B.5.1 and ADA/ABA 402.2

As Built Meas:	1	Quantity:	EACH
Description:	No curb cut at corner (intersection)		
As Built Desc:	No curb ramp at corner		
Solution:	Demolish existing and construct curb cut		
Bar. Severity:	1 Necessary	Cost Estimate:	\$2,500.00
Implementation Priority:	3	Facility Function:	
Implementation Phase:		Implementation Date:	
Official Responsible:			
Notes:	Four - way intersection corners A,B,C,D. Corner A compliant

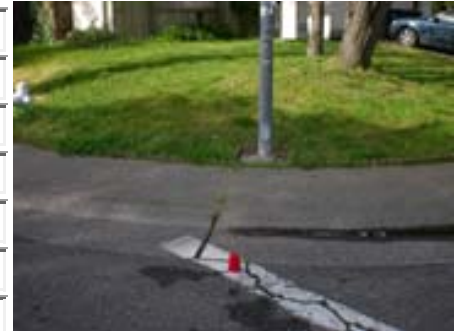
Field Date:	4/14/2011	Report Date:	4/14/2011	Barrier #:	6848
Location:	Woodmore Oaks Dr and Stone Canyon Cir - D				
X Coordinate:	-121.26465				
Y Coordinate:	38.69196				
Barrier Area:	Curb Ramps				
Barrier Type:	No Curb Ramp				
Code Ref:	CBC 1127B.5.1 and ADA/ABA 402.2

As Built Meas:	1	Quantity:	EACH
Description:	No curb cut at corner (intersection)		
As Built Desc:	No curb ramp at corner		
Solution:	Demolish existing and construct curb cut		
Bar. Severity:	1 Necessary	Cost Estimate:	\$2,500.00
Implementation Priority:	3	Facility Function:	
Implementation Phase:		Implementation Date:	
Official Responsible:			
Notes:	Four - way intersection corners A,B,C,D. Corner A compliant

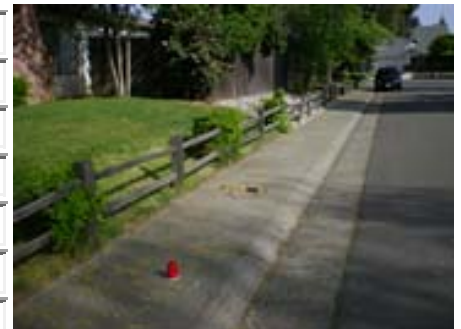
Field Date:	4/14/2011	Report Date:	4/14/2011	Barrier #:	6849
Location:	Stone Canyon Cir - West				
X Coordinate:	-121.26462				
Y Coordinate:	38.69217				
Barrier Area:	Sidewalks				
Barrier Type:	Cross Slope - Existing (4.1% to 4.9%)				
Code Ref:	CBC 1133B.7.1.3 and ADA/ABA 403.3

As Built Meas:	189	Quantity:	LF
Description:	Cross slope exceeds 2.0% (4.1% to 4.9%)		
As Built Desc:	4.6% cross slope		
Solution:	Demolish existing and construct new route		
Bar. Severity:	2 Recommended	Cost Estimate:	\$23,625.00
Implementation Priority:	4	Facility Function:	
Implementation Phase:		Implementation Date:	
Official Responsible:			
Notes:

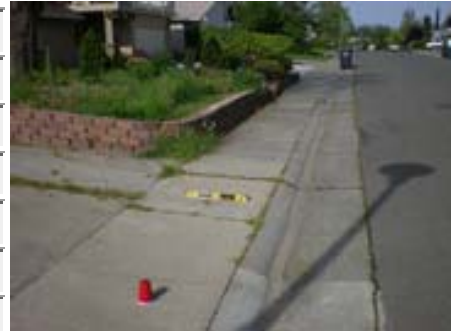
Field Date:	4/14/2011	Report Date:	4/14/2011	Barrier #:	6850
Location:	Stone Canyon Cir - South				
X Coordinate:	-121.26534				
Y Coordinate:	38.69272				
Barrier Area:	Sidewalks				
Barrier Type:	Cross Slope - Existing (4.1% to 4.9%)				
Code Ref:	CBC 1133B.7.1.3 and ADA/ABA 403.3

As Built Meas:	80	Quantity:	LF
Description:	Cross slope exceeds 2.0% (4.1% to 4.9%)		
As Built Desc:	4.5% cross slope		
Solution:	Demolish existing and construct new route		
Bar. Severity:	2 Recommended	Cost Estimate:	\$10,000.00
Implementation Priority:	4	Facility Function:	
Implementation Phase:		Implementation Date:	
Official Responsible:			
Notes:

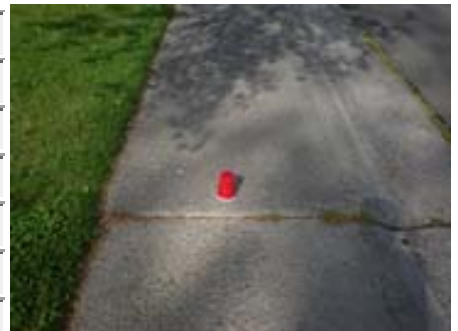
Field Date:	4/14/2011	Report Date:	4/14/2011	Barrier #:	6851
Location:	Stone Canyon Cir - South				
X Coordinate:	-121.26714				
Y Coordinate:	38.69271				
Barrier Area:	Sidewalks				
Barrier Type:	Abrupt Change in Level - > 1/2"				
Code Ref:	CBC 1133B.7.1 and ADA/ABA 303.3

As Built Meas:	4	Quantity:	LF
Description:	Change in level greater than 1/2"		
As Built Desc:	1/2" lip in sidewalk surface		
Solution:	Grind or repair sidewalk to remove trip hazard		
Bar. Severity:	1 Necessary	Cost Estimate:	\$1,000.00
Implementation Priority:	4	Facility Function:	
Implementation Phase:		Implementation Date:	
Official Responsible:			
Notes:

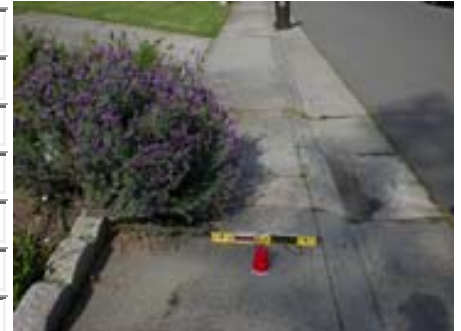
Field Date:	4/14/2011	Report Date:	4/14/2011	Barrier #:	6852
Location:	Stone Canyon Cir - South				
X Coordinate:	-121.26742				
Y Coordinate:	38.69271				
Barrier Area:	Sidewalks				
Barrier Type:	Clear Width - Existing ($\leq 31"$ or less)				
Code Ref:	CBC 1133B.7.1

As Built Meas:	1	Quantity:	LF
Description:	Pedestrian route is not min. 48" wide ($\leq 31"$ or less)		
As Built Desc:	24" clear width due to foliage		
Solution:	Trim foliage to provide min. 48" clear width		
Bar. Severity:	1 Necessary	Cost Estimate:	\$125.00
Implementation Priority:	4	Facility Function:	
Implementation Phase:		Implementation Date:	
Official Responsible:

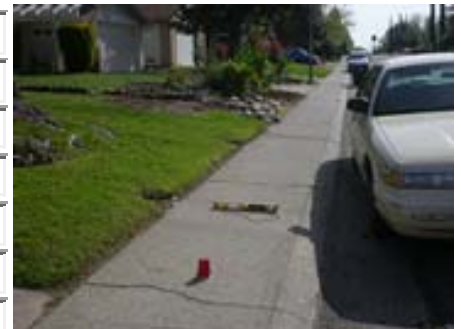
Field Date:	4/14/2011	Report Date:	4/14/2011	Barrier #:	6853
Location:	Woodmore Oaks Dr - North				
X Coordinate:	-121.26771				
Y Coordinate:	38.69209				
Barrier Area:	Sidewalks				
Barrier Type:	Cross Slope - Existing (4.1% to 4.9%)				
Code Ref:	CBC 1133B.7.1.3 and ADA/ABA 403.3

As Built Meas:	196	Quantity:	LF
Description:	Cross slope exceeds 2.0% (4.1% to 4.9%)		
As Built Desc:	4.4% cross slope		
Solution:	Demolish existing and construct new route		
Bar. Severity:	2 Recommended	Cost Estimate:	\$24,500.00
Implementation Priority:	3	Facility Function:	
Implementation Phase:		Implementation Date:	
Official Responsible:

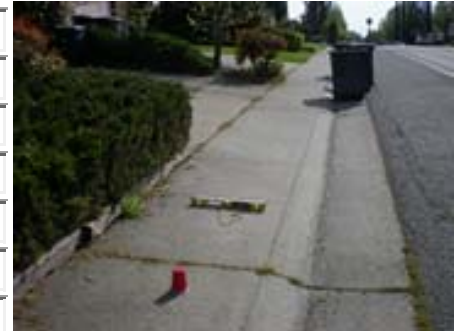
Field Date:	4/14/2011	Report Date:	4/14/2011	Barrier #:	6854
Location:	Woodmore Oaks Dr - North				
X Coordinate:	-121.26676				
Y Coordinate:	38.69212				
Barrier Area:	Sidewalks				
Barrier Type:	Cross Slope - Existing (3.1% to 4.0%)				
Code Ref:	CBC 1133B.7.1.3 and ADA/ABA 403.3

As Built Meas:	108	Quantity:	LF
Description:	Cross slope exceeds 2.0% (3.1% to 4.0%)		
As Built Desc:	3.5% cross slope		
Solution:	Demolish existing and construct new route		
Bar. Severity:	3 Hindrance	Cost Estimate:	\$13,500.00
Implementation Priority:	3	Facility Function:	
Implementation Phase:		Implementation Date:	
Official Responsible:

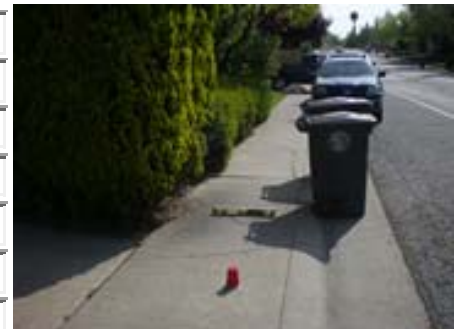
Field Date:	4/14/2011	Report Date:	4/14/2011	Barrier #:	6855
Location:	Woodmore Oaks Dr - North				
X Coordinate:	-121.2656				
Y Coordinate:	38.69212				
Barrier Area:	Sidewalks				
Barrier Type:	Cross Slope - Existing (3.1% to 4.0%)				
Code Ref:	CBC 1133B.7.1.3 and ADA/ABA 403.3

As Built Meas:	100	Quantity:	LF
Description:	Cross slope exceeds 2.0% (3.1% to 4.0%)		
As Built Desc:	3.1% cross slope		
Solution:	Demolish existing and construct new route		
Bar. Severity:	3 Hindrance	Cost Estimate:	\$12,500.00
Implementation Priority:	3	Facility Function:	
Implementation Phase:		Implementation Date:	
Official Responsible:

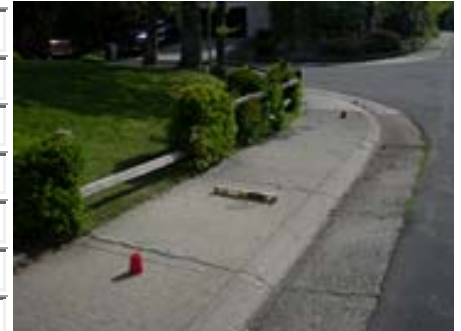
Field Date:	4/14/2011	Report Date:	4/14/2011	Barrier #:	6856
Location:	Woodmore Oaks Dr - North				
X Coordinate:	-121.26481				
Y Coordinate:	38.69215				
Barrier Area:	Sidewalks				
Barrier Type:	Cross Slope - Existing (5.0% or more)				
Code Ref:	CBC 1133B.7.1.3 and ADA/ABA 403.3

As Built Meas:	20	Quantity:	LF
Description:	Cross slope exceeds 2.0% (5.0% or more)		
As Built Desc:	6.0% cross slope		
Solution:	Demolish existing and construct new route		
Bar. Severity:	1 Necessary	Cost Estimate:	\$2,500.00
Implementation Priority:	3	Facility Function:	
Implementation Phase:		Implementation Date:	
Official Responsible:			
Notes:

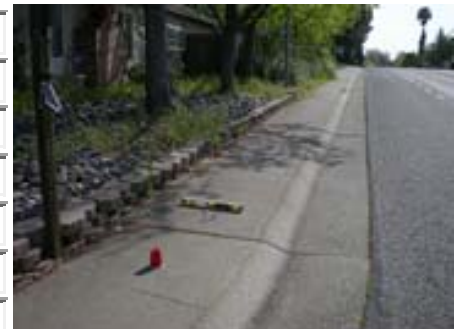
Field Date:	4/14/2011	Report Date:	4/14/2011	Barrier #:	6857
Location:	Woodmore Oaks Dr - North				
X Coordinate:	-121.26435				
Y Coordinate:	38.69213				
Barrier Area:	Sidewalks				
Barrier Type:	Cross Slope - Existing (5.0% or more)				
Code Ref:	CBC 1133B.7.1.3 and ADA/ABA 403.3

As Built Meas:	130	Quantity:	LF
Description:	Cross slope exceeds 2.0% (5.0% or more)		
As Built Desc:	5.8% cross slope		
Solution:	Demolish existing and construct new route		
Bar. Severity:	1 Necessary	Cost Estimate:	\$16,250.00
Implementation Priority:	3	Facility Function:	
Implementation Phase:		Implementation Date:	
Official Responsible:			
Notes:

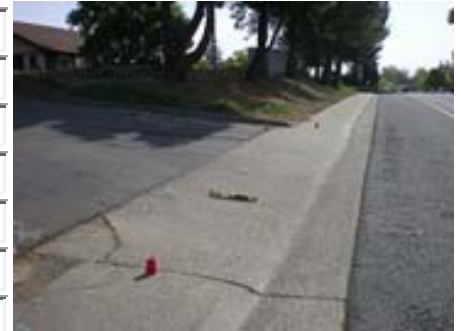
Field Date:	4/14/2011	Report Date:	4/14/2011	Barrier #:	6858
Location:	Woodmore Oaks Dr - North				
X Coordinate:	-121.26399				
Y Coordinate:	38.69213				
Barrier Area:	Sidewalks				
Barrier Type:	Cross Slope - Existing (5.0% or more)				
Code Ref:	CBC 1133B.7.1.3 and ADA/ABA 403.3

As Built Meas:	35	Quantity:	LF
Description:	Cross slope exceeds 2.0% (5.0% or more)		
As Built Desc:	8.6% cross slope		
Solution:	Demolish existing and construct new route		
Bar. Severity:	1 Necessary	Cost Estimate:	\$4,375.00
Implementation Priority:	3	Facility Function:	
Implementation Phase:		Implementation Date:	
Official Responsible:

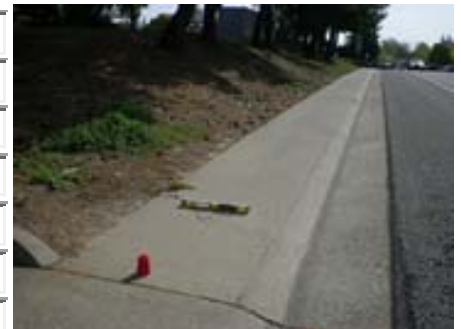
Field Date:	4/14/2011	Report Date:	4/14/2011	Barrier #:	6859
Location:	Woodmore Oaks Dr - North				
X Coordinate:	-121.2639				
Y Coordinate:	38.69213				
Barrier Area:	Sidewalks				
Barrier Type:	Cross Slope - Existing (5.0% or more)				
Code Ref:	CBC 1133B.7.1.3 and ADA/ABA 403.3

As Built Meas:	314	Quantity:	LF
Description:	Cross slope exceeds 2.0% (5.0% or more)		
As Built Desc:	6.8% cross slope		
Solution:	Demolish existing and construct new route		
Bar. Severity:	1 Necessary	Cost Estimate:	\$39,250.00
Implementation Priority:	3	Facility Function:	
Implementation Phase:		Implementation Date:	
Official Responsible:

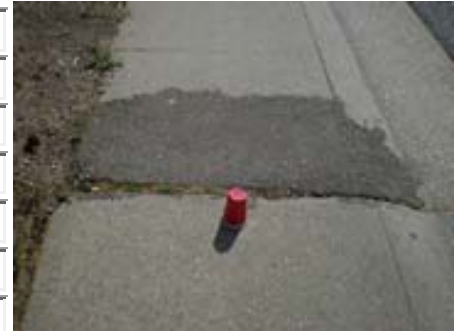
Field Date:	4/14/2011	Report Date:	4/14/2011	Barrier #:	6860
Location:	Woodmore Oaks Dr - North				
X Coordinate:	-121.26307				
Y Coordinate:	38.69212				
Barrier Area:	Sidewalks				
Barrier Type:	Abrupt Change in Level - > 1/2"				
Code Ref:	CBC 1133B.7.1 and ADA/ABA 303.3

As Built Meas:	4	Quantity:	LF
Description:	Change in level greater than 1/2"		
As Built Desc:	1/2" lip in sidewalk surface		
Solution:	Grind or repair sidewalk to remove trip hazard		
Bar. Severity:	1 Necessary	Cost Estimate:	\$1,000.00
Implementation Priority:	3	Facility Function:	
Implementation Phase:		Implementation Date:	
Official Responsible:			
Notes:

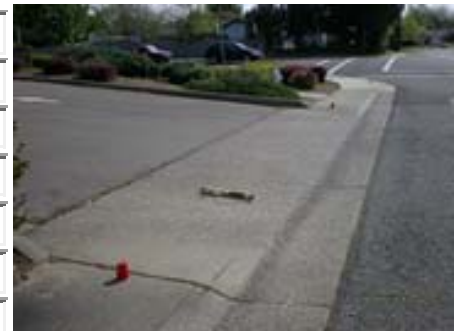
Field Date:	4/14/2011	Report Date:	4/14/2011	Barrier #:	6861
Location:	Woodmore Oaks Dr - North				
X Coordinate:	-121.26279				
Y Coordinate:	38.69214				
Barrier Area:	Sidewalks				
Barrier Type:	Driveway - Existing (5.0% or more)				
Code Ref:	CBC 1133B.7.1.3 and ADA/ABA 403.3

As Built Meas:	35	Quantity:	LF
Description:	Driveway cross slope exceeds 2.0% (5.0% or more)		
As Built Desc:	7.6% cross slope, 10.5% running slope		
Solution:	Provide min. 48" wide level walkway through driveway		
Bar. Severity:	1 Necessary	Cost Estimate:	\$4,375.00
Implementation Priority:	3	Facility Function:	
Implementation Phase:		Implementation Date:	
Official Responsible:			
Notes:

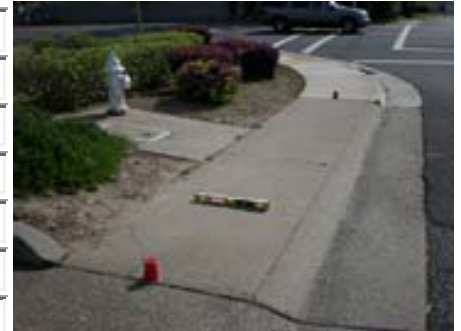
Field Date:	4/14/2011	Report Date:	4/14/2011	Barrier #:	6862
Location:	Woodmore Oaks Dr - North				
X Coordinate:	-121.26265				
Y Coordinate:	38.69219				
Barrier Area:	Sidewalks				
Barrier Type:	Cross Slope - Existing (4.1% to 4.9%)				
Code Ref:	CBC 1133B.7.1.3 and ADA/ABA 403.3

As Built Meas:	20	Quantity:	LF
Description:	Cross slope exceeds 2.0% (4.1% to 4.9%)		
As Built Desc:	4.3% cross slope		
Solution:	Demolish existing and construct new route		
Bar. Severity:	2 Recommended	Cost Estimate:	\$2,500.00
Implementation Priority:	3	Facility Function:	
Implementation Phase:		Implementation Date:	
Official Responsible:

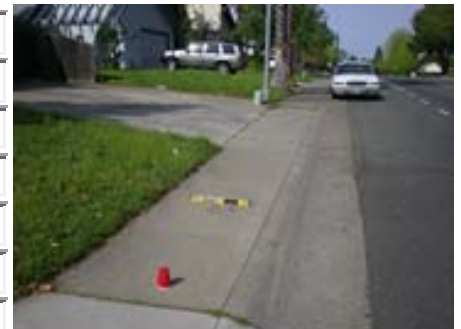
Field Date:	4/14/2011	Report Date:	4/14/2011	Barrier #:	6863
Location:	Woodmore Oaks Dr - South				
X Coordinate:	-121.26261				
Y Coordinate:	38.69203				
Barrier Area:	Sidewalks				
Barrier Type:	Cross Slope - Existing (3.1% to 4.0%)				
Code Ref:	CBC 1133B.7.1.3 and ADA/ABA 403.3

As Built Meas:	145	Quantity:	LF
Description:	Cross slope exceeds 2.0% (3.1% to 4.0%)		
As Built Desc:	3.3% cross slope		
Solution:	Demolish existing and construct new route		
Bar. Severity:	3 Hindrance	Cost Estimate:	\$18,125.00
Implementation Priority:	3	Facility Function:	
Implementation Phase:		Implementation Date:	
Official Responsible:
