DRAFT ADA TRANSITION PLAN UPDATE
NEIGHBORHOOD AREA 9 SONA
SEPTEMBER 20, 2011

CITY OF CITRUS HEIGHTS

The Sunrise Oaks Neighborhood Association (SONA)

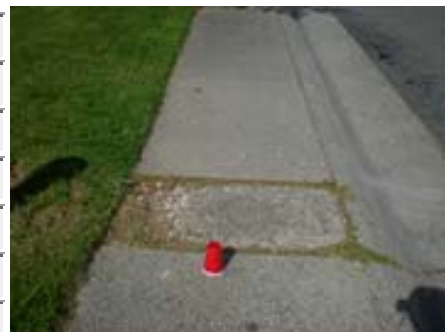
Field Date:	4/14/2011	Report Date:	4/14/2011	Barrier #:	6864
Location:	Woodmore Oaks Dr - South				
X Coordinate:	-121.26293				
Y Coordinate:	38.69201				
Barrier Area:	Sidewalks				
Barrier Type:	Surface Condition - Damaged				
Code Ref:	CBC 1133B.7.1 and ADA/ABA 302.1

As Built Meas:	4	Quantity:	LF
Description:	Surface is not firm and stable (cracked, broken or loose soil, etc.)		
As Built Desc:	Cracked concrete		
Solution:	Repair surface to make firm and stable		
Bar. Severity:	1 Necessary	Cost Estimate:	\$500.00
Implementation Priority:	3	Facility Function:	
Implementation Phase:		Implementation Date:	
Official Responsible:			
Notes:

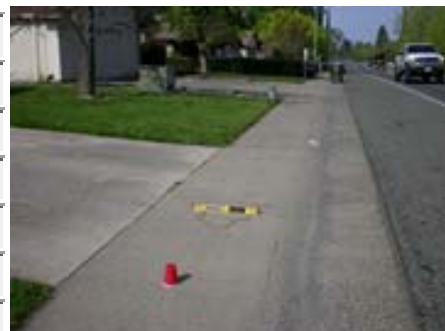
Field Date:	4/14/2011	Report Date:	4/14/2011	Barrier #:	6865
Location:	Woodmore Oaks Dr - South				
X Coordinate:	-121.26323				
Y Coordinate:	38.692				
Barrier Area:	Sidewalks				
Barrier Type:	Cross Slope - Existing (3.1% to 4.0%)				
Code Ref:	CBC 1133B.7.1.3 and ADA/ABA 403.3

As Built Meas:	331	Quantity:	LF
Description:	Cross slope exceeds 2.0% (3.1% to 4.0%)		
As Built Desc:	3.6% cross slope		
Solution:	Demolish existing and construct new route		
Bar. Severity:	3 Hindrance	Cost Estimate:	\$41,375.00
Implementation Priority:	3	Facility Function:	
Implementation Phase:		Implementation Date:	
Official Responsible:			
Notes:

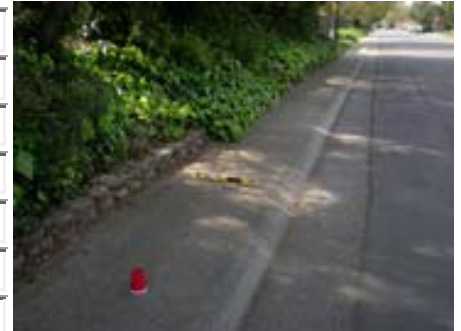
Barrier Type: Cross Slope - Existing (4.1% to 4.9%)

As Built Meas: 194 Quantity: LF

Description: Cross slope exceeds 2.0% (4.1% to 4.9%)

Bar. Severity: 2 Recommended Cost Estimate: \$24,250.00 Status:

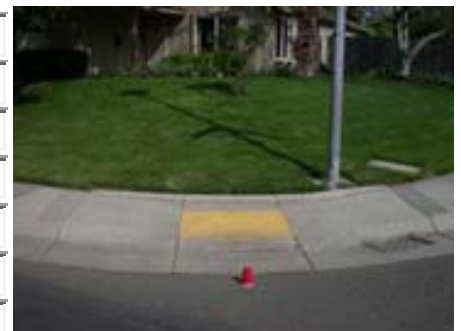
Barrier Type: 12" Grooves - Existing (4.1% to 4.9%)

As Built Meas: 1 Quantity: EACH

Description: 12" grooves at top of curb ramp are not level (4.1% to 4.9%)

Bar. Severity: 2 Recommended Cost Estimate: \$2,500.00 Status:

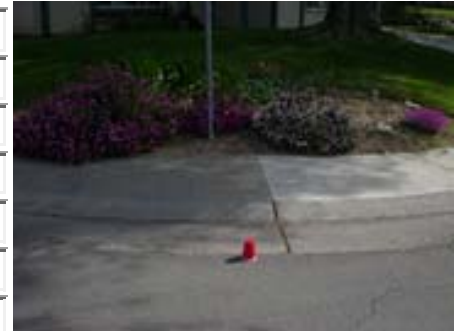
Barrier Type: No Curb Ramp

As Built Meas: 1 Quantity: EACH

Description: No curb cut at corner (intersection)

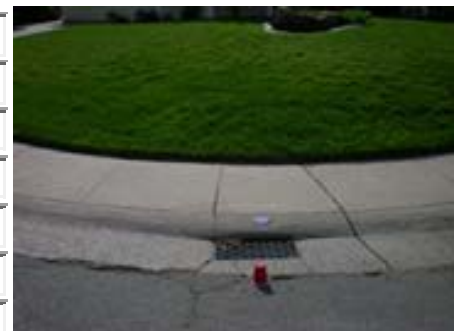
Barrier Type: No Curb Ramp

As Built Meas: 1 Quantity: EACH

Description: No curb cut at corner (intersection)

Notes: Four - way intersection corner A,B,C,D. Corner D compliant

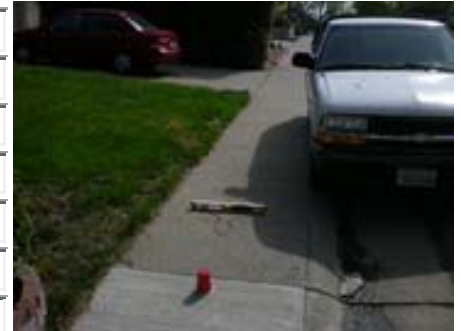
Field Date:	4/14/2011	Report Date:	4/14/2011	Barrier #:	6870
Location:	Camstock Ct - North				
X Coordinate:	-121.26416				
Y Coordinate:	38.69135				
Barrier Area:	Sidewalks				
Barrier Type:	Cross Slope - Existing (4.1% to 4.9%)				
Code Ref:	CBC 1133B.7.1.3 and ADA/ABA 403.3

As Built Meas:	413	Quantity:	LF
Description:	Cross slope exceeds 2.0% (4.1% to 4.9%)		
As Built Desc:	4.3% cross slope		
Solution:	Demolish existing and construct new route		
Bar. Severity:	2 Recommended	Cost Estimate:	\$51,625.00
Implementation Priority:	4	Facility Function:	
Implementation Phase:		Implementation Date:	
Official Responsible:

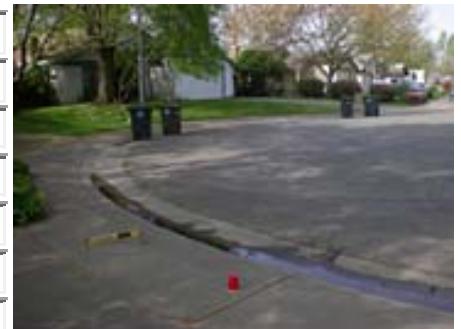
Field Date:	4/14/2011	Report Date:	4/14/2011	Barrier #:	6871
Location:	Camstock Ct - South				
X Coordinate:	-121.26307				
Y Coordinate:	38.69123				
Barrier Area:	Sidewalks				
Barrier Type:	Cross Slope - Existing (4.1% to 4.9%)				
Code Ref:	CBC 1133B.7.1.3 and ADA/ABA 403.3

As Built Meas:	310	Quantity:	LF
Description:	Cross slope exceeds 2.0% (4.1% to 4.9%)		
As Built Desc:	4.3% cross slope		
Solution:	Demolish existing and construct new route		
Bar. Severity:	2 Recommended	Cost Estimate:	\$38,750.00
Implementation Priority:	4	Facility Function:	
Implementation Phase:		Implementation Date:	
Official Responsible:

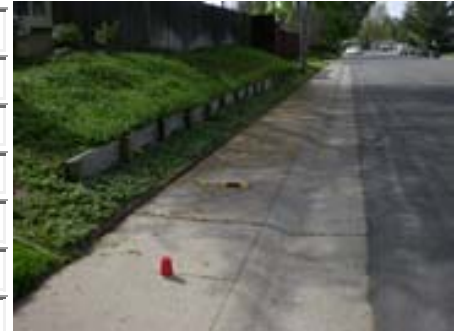
Field Date:	4/14/2011	Report Date:	4/14/2011	Barrier #:	6872
Location:	Larwin Dr - East				
X Coordinate:	-121.26446				
Y Coordinate:	38.69117				
Barrier Area:	Sidewalks				
Barrier Type:	Cross Slope - Existing (3.1% to 4.0%)				
Code Ref:	CBC 1133B.7.1.3 and ADA/ABA 403.3

As Built Meas:	190	Quantity:	LF
Description:	Cross slope exceeds 2.0% (3.1% to 4.0%)		
As Built Desc:	3.5% cross slope		
Solution:	Demolish existing and construct new route		
Bar. Severity:	3 Hindrance	Cost Estimate:	\$23,750.00
Implementation Priority:	2	Facility Function:	
Implementation Phase:		Implementation Date:	
Official Responsible:

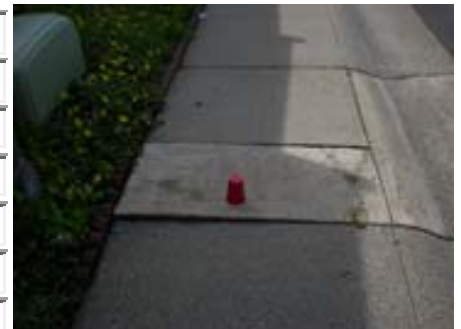
Field Date:	4/14/2011	Report Date:	4/14/2011	Barrier #:	6873
Location:	Larwin Dr - East				
X Coordinate:	-121.26446				
Y Coordinate:	38.69094				
Barrier Area:	Sidewalks				
Barrier Type:	Abrupt Change in Level - > 1/2"				
Code Ref:	CBC 1133B.7.1 and ADA/ABA 303.3

As Built Meas:	4	Quantity:	LF
Description:	Change in level greater than 1/2"		
As Built Desc:	1/2" lip in sidewalk surface		
Solution:	Grind or repair sidewalk to remove trip hazard		
Bar. Severity:	1 Necessary	Cost Estimate:	\$1,000.00
Implementation Priority:	2	Facility Function:	
Implementation Phase:		Implementation Date:	
Official Responsible:

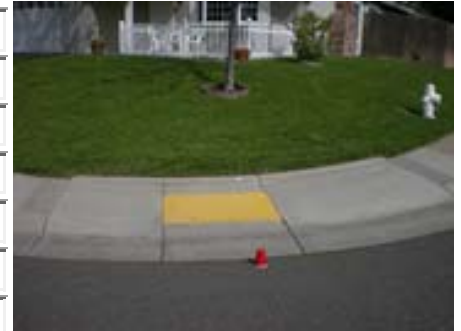
Barrier Type: 12" Grooves - Existing (4.1% to 4.9%)

Description: 12" grooves at top of curb ramp are not level (4.1% to 4.9%)

Bar. Severity: 2 Recommended

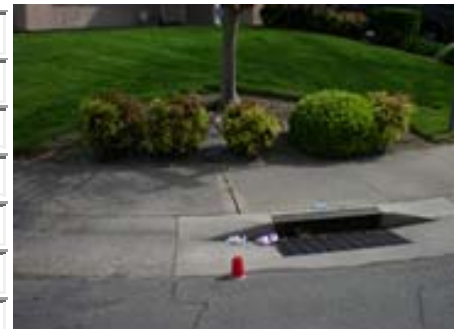
Barrier Type: No Curb Ramp

Description: No curb cut at corner (intersection)

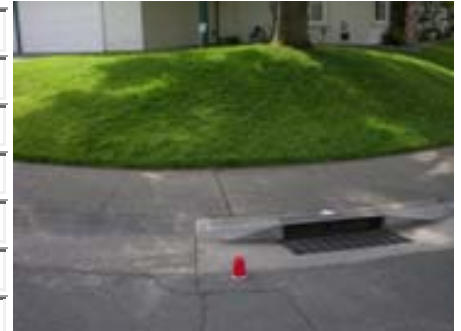
Barrier Type: No Curb Ramp

Description: No curb cut at corner (intersection)

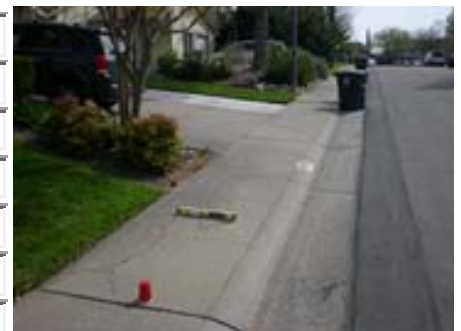
Barrier Type: Cross Slope - Existing (4.1% to 4.9%)

Description: Cross slope exceeds 2.0% (4.1% to 4.9%)

Bar. Severity: 2 Recommended Cost Estimate: \$59,000.00 Status:

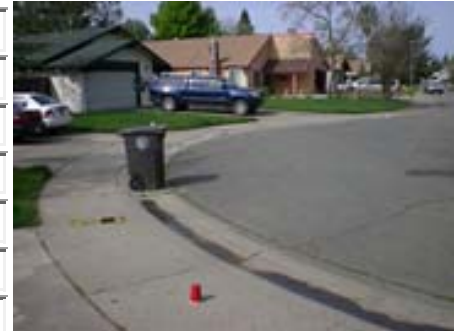
Barrier Type: Cross Slope - Existing (3.1% to 4.0%)

Description: Cross slope exceeds 2.0% (3.1% to 4.0%)

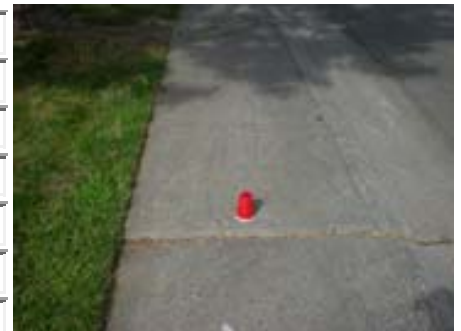
Barrier Type: Abrupt Change in Level - > 1/2"

Description: Change in level greater than 1/2"

Solution: Grind or repair sidewalk to remove trip hazard

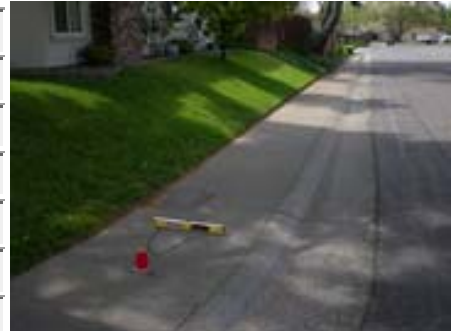
Field Date:	4/14/2011	Report Date:	4/14/2011	Barrier #:	6880A
Location:	Larwin Dr - East				
X Coordinate:	-121.26445				
Y Coordinate:	38.69043				
Barrier Area:	Sidewalks				
Barrier Type:	Cross Slope - Existing (5.0% or more)				
Code Ref:	CBC 1133B.7.1.3 and ADA/ABA 403.3

As Built Meas:	205	Quantity:	LF
Description:	Cross slope exceeds 2.0% (5.0% or more)		
As Built Desc:	5.1% cross slope		
Solution:	Demolish existing and construct new route		
Bar. Severity:	1 Necessary	Cost Estimate:	\$25,625.00
Implementation Priority:	2	Facility Function:	
Implementation Phase:		Implementation Date:	
Official Responsible:

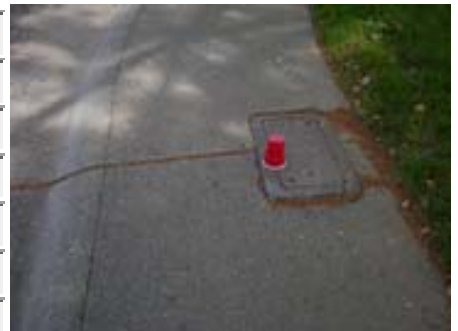
Field Date:	4/14/2011	Report Date:	4/14/2011	Barrier #:	6880B
Location:	Larwin Dr - East				
X Coordinate:	-121.26443				
Y Coordinate:	38.69037				
Barrier Area:	Sidewalks				
Barrier Type:	Abrupt Change in Level - > 1/2"				
Code Ref:	CBC 1133B.7.1 and ADA/ABA 303.3

As Built Meas:	4	Quantity:	LF
Description:	Change in level greater than 1/2"		
As Built Desc:	1/2" lip in sidewalk surface		
Solution:	Grind or repair sidewalk to remove trip hazard		
Bar. Severity:	1 Necessary	Cost Estimate:	\$1,000.00
Implementation Priority:	2	Facility Function:	
Implementation Phase:		Implementation Date:	
Official Responsible:

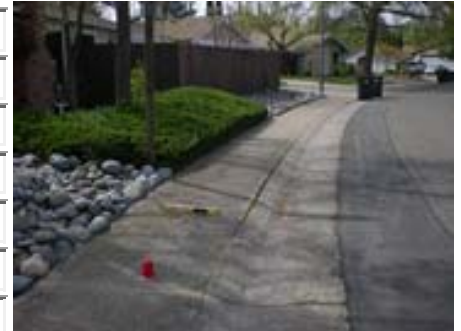
Field Date:	4/14/2011	Report Date:	4/14/2011	Barrier #:	6881
Location:	Larwin Dr - East				
X Coordinate:	-121.26443				
Y Coordinate:	38.68969				
Barrier Area:	Sidewalks				
Barrier Type:	Cross Slope - Existing (5.0% or more)				
Code Ref:	CBC 1133B.7.1.3 and ADA/ABA 403.3

As Built Meas:	156	Quantity:	LF
Description:	Cross slope exceeds 2.0% (5.0% or more)		
As Built Desc:	7.1% cross slope		
Solution:	Demolish existing and construct new route		
Bar. Severity:	1 Necessary	Cost Estimate:	\$19,500.00
Implementation Priority:	2	Facility Function:	
Implementation Phase:		Implementation Date:	
Official Responsible:

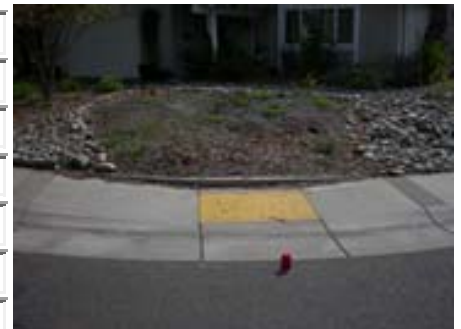
Field Date:	4/14/2011	Report Date:	4/14/2011	Barrier #:	6882
Location:	Larwin Dr and Willow Glen Ct - Corner C				
X Coordinate:	-121.26464				
Y Coordinate:	38.68925				
Barrier Area:	Curb Ramps				
Barrier Type:	12" Grooves - Existing (4.1% to 4.9%)				
Code Ref:	CBC 1127B.5.6

As Built Meas:	1	Quantity:	EACH
Description:	12" grooves at top of curb ramp are not level (4.1% to 4.9%)		
As Built Desc:	4.3% at 12" grooves		
Solution:	Demolish existing and construct new curb ramp		
Bar. Severity:	2 Recommended	Cost Estimate:	\$2,500.00
Implementation Priority:	2	Facility Function:	
Implementation Phase:		Implementation Date:	
Official Responsible:

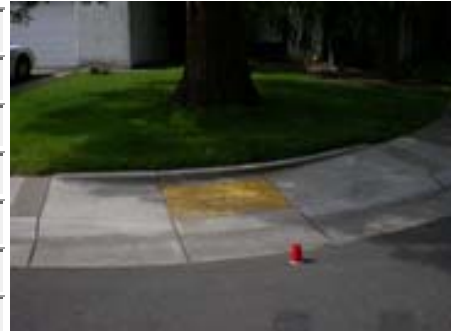
Barrier Type: 12" Grooves - Existing (3.1% to 4.0%)

Description: 12" grooves at top of curb ramp are not level (3.1% to 4.0%)

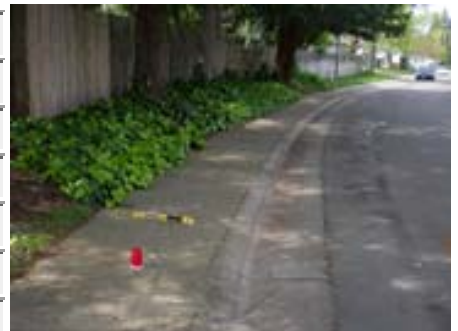
Barrier Type: Cross Slope - Existing (5.0% or more)

Description: Cross slope exceeds 2.0% (5.0% or more)

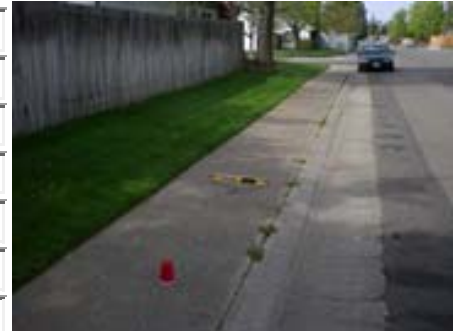
Field Date:	4/14/2011	Report Date:	4/14/2011	Barrier #:	6884B
Location:	Larwin Dr - South				
X Coordinate:	-121.26512				
Y Coordinate:	38.68903				
Barrier Area:	Sidewalks				
Barrier Type:	Cross Slope - Existing (5.0% or more)				
Code Ref:	CBC 1133B.7.1.3 and ADA/ABA 403.3

As Built Meas:	102	Quantity:	LF
Description:	Cross slope exceeds 2.0% (5.0% or more)		
As Built Desc:	5.1% cross slope		
Solution:	Demolish existing and construct new route		
Bar. Severity:	1 Necessary	Cost Estimate:	\$12,750.00
Implementation Priority:	2	Facility Function:	
Implementation Phase:		Implementation Date:	
Official Responsible:

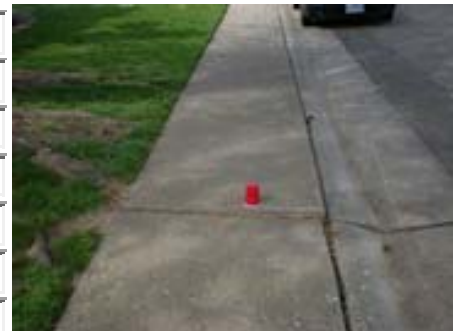
Field Date:	4/14/2011	Report Date:	4/14/2011	Barrier #:	6884C
Location:	Larwin Dr - South				
X Coordinate:	-121.26525				
Y Coordinate:	38.68898				
Barrier Area:	Sidewalks				
Barrier Type:	Abrupt Change in Level - > 1/2"				
Code Ref:	CBC 1133B.7.1 and ADA/ABA 303.3

As Built Meas:	4	Quantity:	LF
Description:	Change in level greater than 1/2"		
As Built Desc:	1/2" lip in sidewalk surface		
Solution:	Grind or repair sidewalk to remove trip hazard		
Bar. Severity:	1 Necessary	Cost Estimate:	\$1,000.00
Implementation Priority:	2	Facility Function:	
Implementation Phase:		Implementation Date:	
Official Responsible:

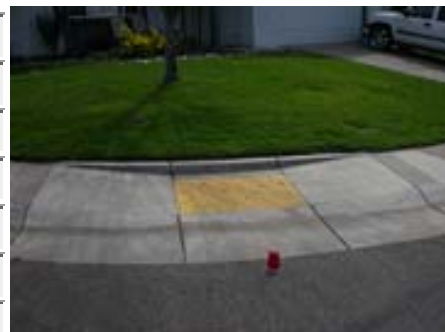
Field Date:	4/14/2011	Report Date:	4/14/2011	Barrier #:	6885
Location:	Larwin Dr and Shady Grove Ct - Corner C				
X Coordinate:	-121.26544				
Y Coordinate:	38.6889				
Barrier Area:	Sidewalks				
Barrier Type:	Cross Slope - Existing (4.1% to 4.9%)				
Code Ref:	CBC 1133B.7.1.3 and ADA/ABA 403.3

As Built Meas:	50	Quantity:	LF
Description:	Cross slope exceeds 2.0% (4.1% to 4.9%)		
As Built Desc:	4.5% cross slope		
Solution:	Demolish existing and construct new route		
Bar. Severity:	2 Recommended	Cost Estimate:	\$6,250.00
Implementation Priority:	2	Facility Function:	
Implementation Phase:		Implementation Date:	
Official Responsible:			
Notes:	Two - way intersection corners C, D. Corner D compliant

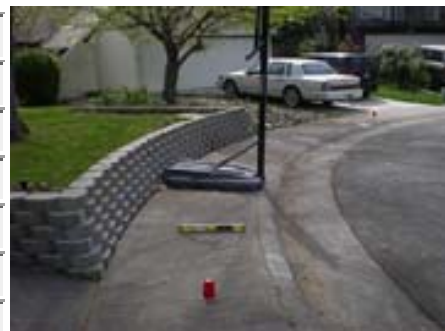
Field Date:	4/14/2011	Report Date:	4/14/2011	Barrier #:	6886
Location:	Shady Grove Ct - East				
X Coordinate:	-121.26495				
Y Coordinate:	38.68858				
Barrier Area:	Sidewalks				
Barrier Type:	Cross Slope - Existing (4.1% to 4.9%)				
Code Ref:	CBC 1133B.7.1.3 and ADA/ABA 403.3

As Built Meas:	50	Quantity:	LF
Description:	Cross slope exceeds 2.0% (4.1% to 4.9%)		
As Built Desc:	4.5% cross slope		
Solution:	Demolish existing and construct new route		
Bar. Severity:	2 Recommended	Cost Estimate:	\$6,250.00
Implementation Priority:	2	Facility Function:	
Implementation Phase:		Implementation Date:	
Official Responsible:			
Notes:

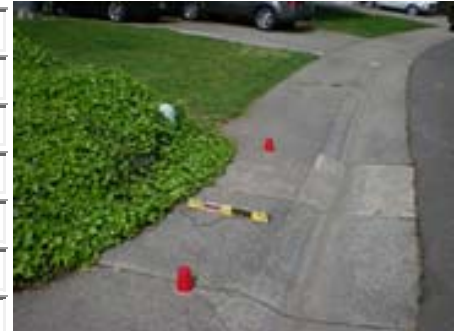
Field Date:	4/14/2011	Report Date:	4/14/2011	Barrier #:	6887A
Location:	Shady Grove Ct - West				
X Coordinate:	-121.26528				
Y Coordinate:	38.68852				
Barrier Area:	Sidewalks				
Barrier Type:	Cross Slope - Existing (3.1% to 4.0%)				
Code Ref:	CBC 1133B.7.1.3 and ADA/ABA 403.3

As Built Meas:	210	Quantity:	LF
Description:	Cross slope exceeds 2.0% (3.1% to 4.0%)		
As Built Desc:	3.5% cross slope		
Solution:	Demolish existing and construct new route		
Bar. Severity:	3 Hindrance	Cost Estimate:	\$26,250.00
Implementation Priority:	2	Facility Function:	
Implementation Phase:		Implementation Date:	
Official Responsible:

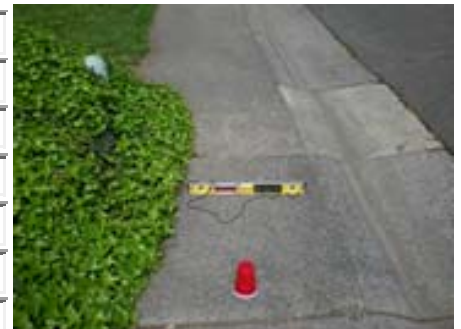
Field Date:	4/14/2011	Report Date:	4/14/2011	Barrier #:	6887B
Location:	Shady Grove Ct - West				
X Coordinate:	-121.26529				
Y Coordinate:	38.68849				
Barrier Area:	Sidewalks				
Barrier Type:	Clear Width - Existing ($\leq 31"$ or less)				
Code Ref:	CBC 1133B.7.1

As Built Meas:	1	Quantity:	LF
Description:	Pedestrian route is not min. 48" wide ($\leq 31"$ or less)		
As Built Desc:	24" clear width due to foligae		
Solution:	Trim foliage to provide min. 48" clear width		
Bar. Severity:	1 Necessary	Cost Estimate:	\$125.00
Implementation Priority:	2	Facility Function:	
Implementation Phase:		Implementation Date:	
Official Responsible:

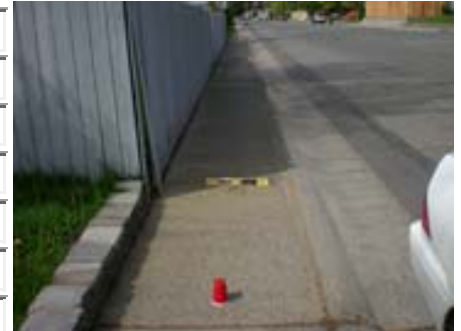
Field Date:	4/14/2011	Report Date:	4/14/2011	Barrier #:	6888
Location:	Larwin Dr - South				
X Coordinate:	-121.26574				
Y Coordinate:	38.68884				
Barrier Area:	Sidewalks				
Barrier Type:	Cross Slope - Existing (3.1% to 4.0%)				
Code Ref:	CBC 1133B.7.1.3 and ADA/ABA 403.3

As Built Meas:	86	Quantity:	LF
Description:	Cross slope exceeds 2.0% (3.1% to 4.0%)		
As Built Desc:	3.7% cross slope		
Solution:	Demolish existing and construct new route		
Bar. Severity:	3 Hindrance	Cost Estimate:	\$10,750.00
Implementation Priority:	2	Facility Function:	
Implementation Phase:		Implementation Date:	
Official Responsible:

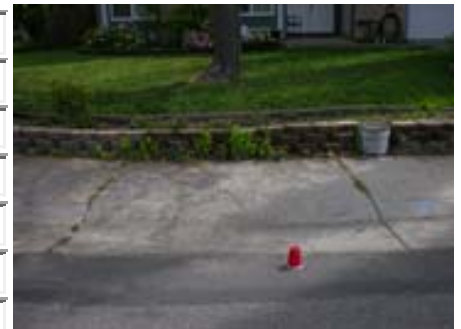
Field Date:	4/14/2011	Report Date:	4/14/2011	Barrier #:	6889
Location:	Larwin Dr and Plumtree Ct - Corner C				
X Coordinate:	-121.26656				
Y Coordinate:	38.68859				
Barrier Area:	Curb Ramps				
Barrier Type:	No Curb Ramp				
Code Ref:	CBC 1127B.5.1 and ADA/ABA 402.2

As Built Meas:	1	Quantity:	EACH
Description:	No curb cut at corner (intersection)		
As Built Desc:	No curb ramp at corner		
Solution:	Demolish existing and construct curb cut		
Bar. Severity:	1 Necessary	Cost Estimate:	\$2,500.00
Implementation Priority:	2	Facility Function:	
Implementation Phase:		Implementation Date:	
Official Responsible:

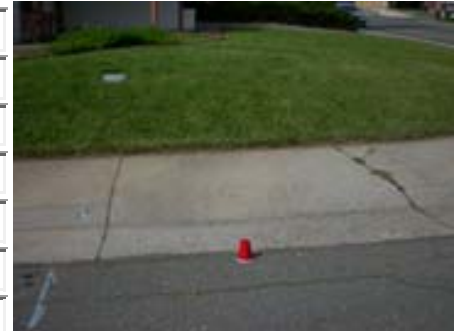
Field Date:	4/14/2011	Report Date:	4/14/2011	Barrier #:	6890
Location:	Larwin Dr and Plumtree Ct - Corner D				
X Coordinate:	-121.26672				
Y Coordinate:	38.68854				
Barrier Area:	Curb Ramps				
Barrier Type:	No Curb Ramp - Depressed Existing Curb				
Code Ref:	CBC 1127B.5.1 and ADA/ABA 402.2

As Built Meas:	1	Quantity:	EACH
Description:	No compliant curb cut at corner (intersection)		
As Built Desc:	10.0% running slope at depressed area		
Solution:	Demolish existing and construct curb cut		
Bar. Severity:	1 Necessary	Cost Estimate:	\$2,500.00
Implementation Priority:	2	Facility Function:	
Implementation Phase:		Implementation Date:	
Official Responsible:			
Notes:	Two - way intersection corners C,D

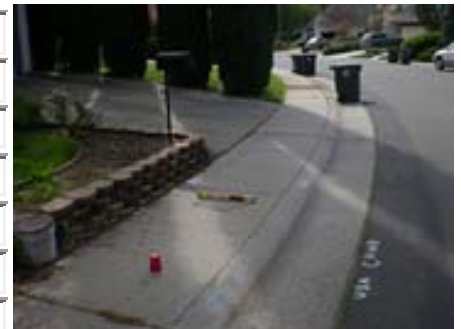
Field Date:	4/14/2011	Report Date:	4/14/2011	Barrier #:	6891
Location:	Plumtree Ct - East				
X Coordinate:	-121.26652				
Y Coordinate:	38.68851				
Barrier Area:	Sidewalks				
Barrier Type:	Cross Slope - Existing (4.1% to 4.9%)				
Code Ref:	CBC 1133B.7.1.3 and ADA/ABA 403.3

As Built Meas:	364	Quantity:	LF
Description:	Cross slope exceeds 2.0% (4.1% to 4.9%)		
As Built Desc:	4.9% cross slope		
Solution:	Demolish existing and construct new route		
Bar. Severity:	2 Recommended	Cost Estimate:	\$45,500.00
Implementation Priority:	2	Facility Function:	
Implementation Phase:		Implementation Date:	
Official Responsible:			
Notes:

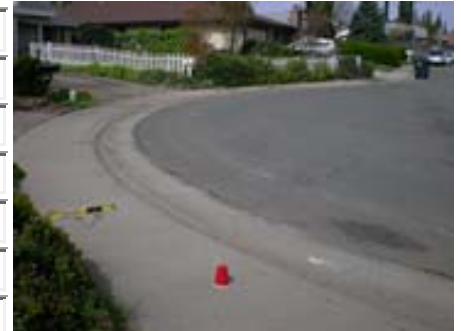
Field Date:	4/14/2011	Report Date:	4/14/2011	Barrier #:	6892
Location:	Plumtree Ct - East				
X Coordinate:	-121.26599				
Y Coordinate:	38.688				
Barrier Area:	Sidewalks				
Barrier Type:	Cross Slope - Existing (3.1% to 4.0%)				
Code Ref:	CBC 1133B.7.1.3 and ADA/ABA 403.3

As Built Meas:	293	Quantity:	LF
Description:	Cross slope exceeds 2.0% (3.1% to 4.0%)		
As Built Desc:	3.7% cross slope		
Solution:	Demolish existing and construct new route		
Bar. Severity:	3 Hindrance	Cost Estimate:	\$36,625.00
Implementation Priority:	2	Facility Function:	
Implementation Phase:		Implementation Date:	
Official Responsible:

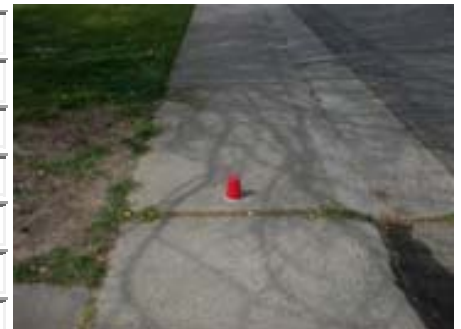
Field Date:	4/14/2011	Report Date:	4/14/2011	Barrier #:	6893
Location:	Larwin Dr - South				
X Coordinate:	-121.26707				
Y Coordinate:	38.68846				
Barrier Area:	Sidewalks				
Barrier Type:	Abrupt Change in Level - > 1/2"				
Code Ref:	CBC 1133B.7.1 and ADA/ABA 303.3

As Built Meas:	4	Quantity:	LF
Description:	Change in level greater than 1/2"		
As Built Desc:	1/2" lip in sidewalk surface		
Solution:	Grind or repair sidewalk to remove trip hazard		
Bar. Severity:	1 Necessary	Cost Estimate:	\$1,000.00
Implementation Priority:	2	Facility Function:	
Implementation Phase:		Implementation Date:	
Official Responsible:

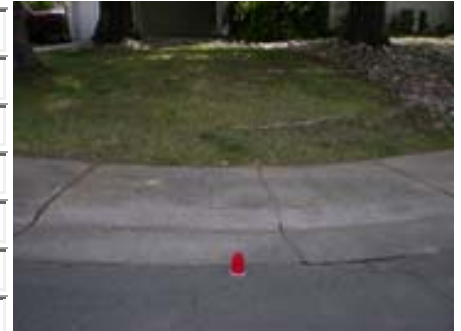
Field Date:	4/14/2011	Report Date:	4/14/2011	Barrier #:	6894
Location:	Larwin Dr and Old Oak Ct - Corner C				
X Coordinate:	-121.26759				
Y Coordinate:	38.68827				
Barrier Area:	Curb Ramps				
Barrier Type:	No Curb Ramp				
Code Ref:	CBC 1127B.5.1 and ADA/ABA 402.2

As Built Meas:	1	Quantity:	EACH
Description:	No curb cut at corner (intersection)		
As Built Desc:	No curb ramp at corner		
Solution:	Demolish existing and construct curb cut		
Bar. Severity:	1 Necessary	Cost Estimate:	\$2,500.00
Implementation Priority:	2	Facility Function:	
Implementation Phase:		Implementation Date:	
Official Responsible:			
Notes:	Two - way intersection corners C,D

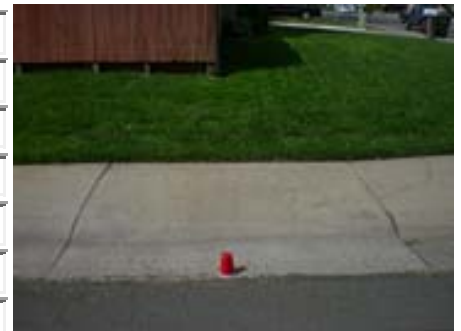
Field Date:	4/14/2011	Report Date:	4/14/2011	Barrier #:	6895
Location:	Larwin Dr and Old Oak Ct - Corner D				
X Coordinate:	-121.26773				
Y Coordinate:	38.68818				
Barrier Area:	Curb Ramps				
Barrier Type:	No Curb Ramp - Depressed Existing Curb				
Code Ref:	CBC 1127B.5.1 and ADA/ABA 402.2

As Built Meas:	1	Quantity:	EACH
Description:	No compliant curb cut at corner (intersection)		
As Built Desc:	7.0% running slope at depressed area		
Solution:	Demolish existing and construct curb cut		
Bar. Severity:	1 Necessary	Cost Estimate:	\$2,500.00
Implementation Priority:	2	Facility Function:	
Implementation Phase:		Implementation Date:	
Official Responsible:			
Notes:	Two - way intersection corners C,D

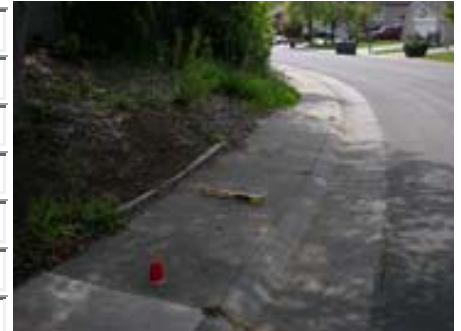
Field Date:	4/14/2011	Report Date:	4/14/2011	Barrier #:	6896
Location:	Old Oak Ct - East				
X Coordinate:	-121.26757				
Y Coordinate:	38.68818				
Barrier Area:	Sidewalks				
Barrier Type:	Cross Slope - Existing (5.0% or more)				
Code Ref:	CBC 1133B.7.1.3 and ADA/ABA 403.3

As Built Meas:	528	Quantity:	LF
Description:	Cross slope exceeds 2.0% (5.0% or more)		
As Built Desc:	5.2% cross slope		
Solution:	Demolish existing and construct new route		
Bar. Severity:	1 Necessary	Cost Estimate:	\$66,000.00
Implementation Priority:	2	Facility Function:	
Implementation Phase:		Implementation Date:	
Official Responsible:

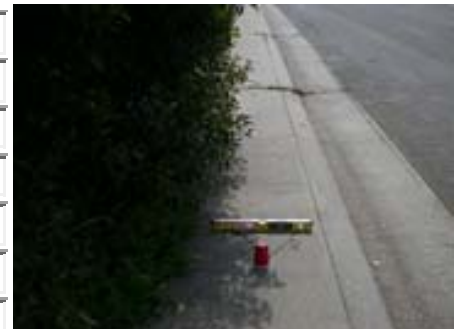
Field Date:	4/14/2011	Report Date:	4/14/2011	Barrier #:	6897
Location:	Old Oak Ct - East				
X Coordinate:	-121.26735				
Y Coordinate:	38.68802				
Barrier Area:	Sidewalks				
Barrier Type:	Clear Width - Existing ($\leq 31"$ or less)				
Code Ref:	CBC 1133B.7.1

As Built Meas:	1	Quantity:	LF
Description:	Pedestrian route is not min. 48" wide ($\leq 31"$ or less)		
As Built Desc:	24" clear width due to foliage		
Solution:	Trim foliage to provide min. 48" clear width		
Bar. Severity:	1 Necessary	Cost Estimate:	\$125.00
Implementation Priority:	2	Facility Function:	
Implementation Phase:		Implementation Date:	
Official Responsible:

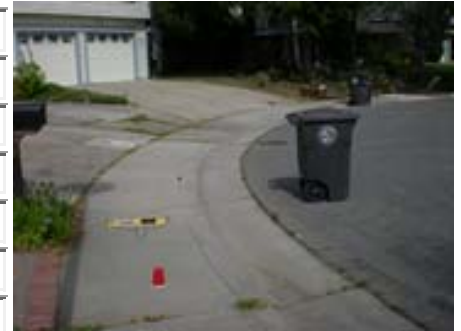
Field Date:	4/14/2011	Report Date:	4/14/2011	Barrier #:	6898A
Location:	Old Oak Ct - West				
X Coordinate:	-121.26694				
Y Coordinate:	38.68712				
Barrier Area:	Sidewalks				
Barrier Type:	Cross Slope - Existing (4.1% to 4.9%)				
Code Ref:	CBC 1133B.7.1.3 and ADA/ABA 403.3

As Built Meas:	542	Quantity:	LF
Description:	Cross slope exceeds 2.0% (4.1% to 4.9%)		
As Built Desc:	4.9% cross slope		
Solution:	Demolish existing and construct new route		
Bar. Severity:	2 Recommended	Cost Estimate:	\$67,750.00
Implementation Priority:	2	Facility Function:	
Implementation Phase:		Implementation Date:	
Official Responsible:			
Notes:

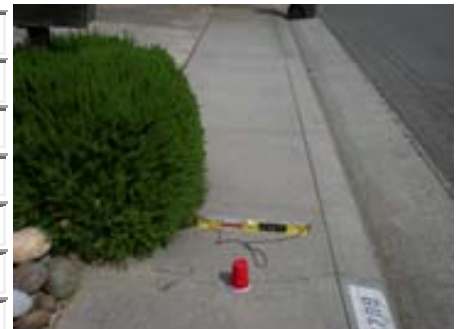
Field Date:	4/14/2011	Report Date:	4/14/2011	Barrier #:	6898B
Location:	Old Oak Ct - West				
X Coordinate:	-121.26697				
Y Coordinate:	38.68738				
Barrier Area:	Sidewalks				
Barrier Type:	Clear Width - Existing ($\leq 31"$ or less)				
Code Ref:	CBC 1133B.7.1

As Built Meas:	1	Quantity:	LF
Description:	Pedestrian route is not min. 48" wide ($\leq 31"$ or less)		
As Built Desc:	24" clear width due to foliage		
Solution:	Trim foliage to provide min. 48" clear width		
Bar. Severity:	1 Necessary	Cost Estimate:	\$125.00
Implementation Priority:	2	Facility Function:	
Implementation Phase:		Implementation Date:	
Official Responsible:			
Notes:

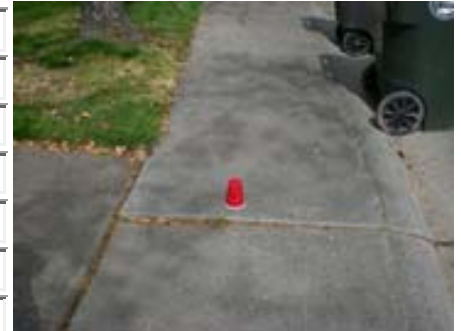
Field Date:	4/14/2011	Report Date:	4/14/2011	Barrier #:	6898C
Location:	Old Oak Ct - West				
X Coordinate:	-121.26706				
Y Coordinate:	38.68769				
Barrier Area:	Sidewalks				
Barrier Type:	Abrupt Change in Level - > 1/2"				
Code Ref:	CBC 1133B.7.1 and ADA/ABA 303.3

As Built Meas:	4	Quantity:	LF
Description:	Change in level greater than 1/2"		
As Built Desc:	1/2" lip in sidewalk surface		
Solution:	Grind or repair sidewalk to remove trip hazard		
Bar. Severity:	1 Necessary	Cost Estimate:	\$1,000.00
Implementation Priority:	2	Facility Function:	
Implementation Phase:		Implementation Date:	
Official Responsible:			
Notes:

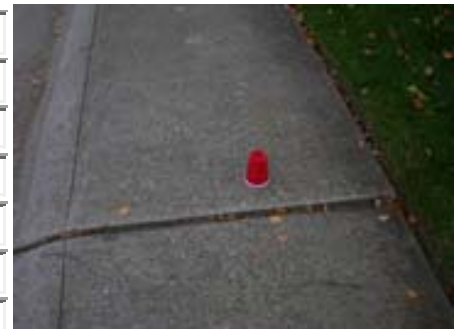
Field Date:	4/14/2011	Report Date:	4/14/2011	Barrier #:	6899
Location:	Larwin Dr - South				
X Coordinate:	-121.26836				
Y Coordinate:	38.68808				
Barrier Area:	Sidewalks				
Barrier Type:	Abrupt Change in Level - > 1/2"				
Code Ref:	CBC 1133B.7.1 and ADA/ABA 303.3

As Built Meas:	4	Quantity:	LF
Description:	Change in level greater than 1/2"		
As Built Desc:	1/2" lip in sidewalk surface		
Solution:	Grind or repair sidewalk to remove trip hazard		
Bar. Severity:	1 Necessary	Cost Estimate:	\$1,000.00
Implementation Priority:	2	Facility Function:	
Implementation Phase:		Implementation Date:	
Official Responsible:			
Notes:

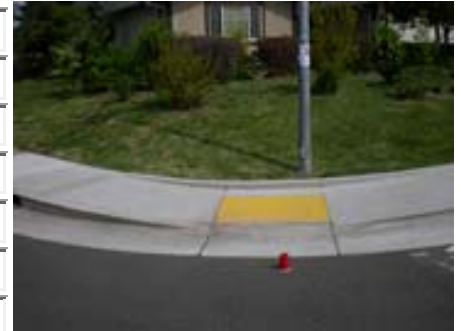
Field Date:	4/15/2011	Report Date:	4/15/2011	Barrier #:	6900
Location:	Larwin Dr and Canoe Birch Ct - Corner B				
X Coordinate:	-121.26887				
Y Coordinate:	38.68805				
Barrier Area:	Curb Ramps				
Barrier Type:	12" Grooves - Existing (4.1% to 4.9%)				
Code Ref:	CBC 1127B.5.6

As Built Meas:	1	Quantity:	EACH
Description:	12" grooves at top of curb ramp are not level (4.1% to 4.9%)		
As Built Desc:	4.1% at 12" grooves		
Solution:	Demolish existing and construct new curb ramp		
Bar. Severity:	2 Recommended	Cost Estimate:	\$2,500.00
Implementation Priority:	2	Facility Function:	
Implementation Phase:		Implementation Date:	
Official Responsible:

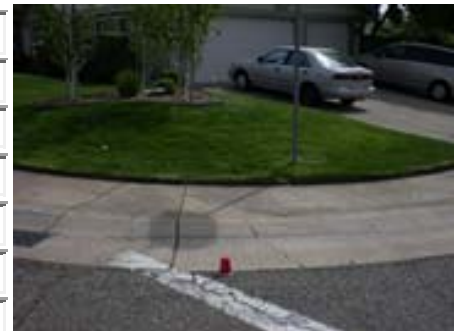
Field Date:	4/15/2011	Report Date:	4/15/2011	Barrier #:	6901
Location:	Larwin Dr and Sweet Gum Ct - Corner C				
X Coordinate:	-121.26873				
Y Coordinate:	38.68792				
Barrier Area:	Curb Ramps				
Barrier Type:	No Curb Ramp				
Code Ref:	CBC 1127B.5.1 and ADA/ABA 402.2

As Built Meas:	1	Quantity:	EACH
Description:	No curb cut at corner (intersection)		
As Built Desc:	No curb ramp at corner		
Solution:	Demolish existing and construct curb cut		
Bar. Severity:	1 Necessary	Cost Estimate:	\$2,500.00
Implementation Priority:	2	Facility Function:	
Implementation Phase:		Implementation Date:	
Official Responsible:

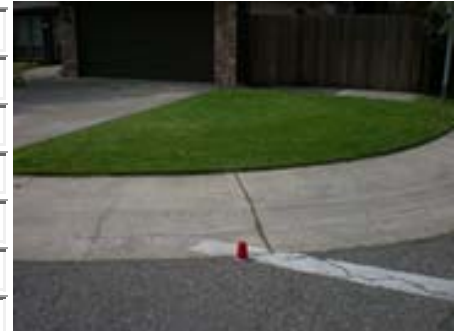
Field Date:	4/15/2011	Report Date:	4/15/2011	Barrier #:	6902
Location:	Larwin Dr and Sweet Gum Ct - Corner D				
X Coordinate:	-121.26881				
Y Coordinate:	38.68784				
Barrier Area:	Curb Ramps				
Barrier Type:	No Curb Ramp				
Code Ref:	CBC 1127B.5.1 and ADA/ABA 402.2

As Built Meas:	1	Quantity:	EACH
Description:	No curb cut at corner (intersection)		
As Built Desc:	No curb ramp at corner		
Solution:	Demolish existing and construct curb cut		
Bar. Severity:	1 Necessary	Cost Estimate:	\$2,500.00
Implementation Priority:	2	Facility Function:	
Implementation Phase:		Implementation Date:	
Official Responsible:

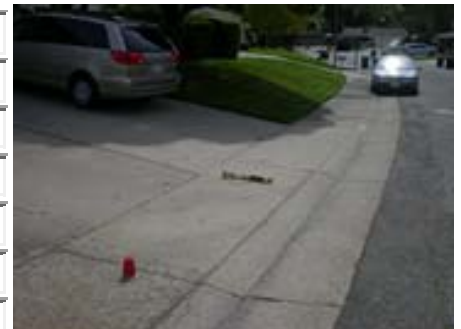
Field Date:	4/15/2011	Report Date:	4/15/2011	Barrier #:	6903
Location:	Sweet Gum Ct - East				
X Coordinate:	-121.26868				
Y Coordinate:	38.68789				
Barrier Area:	Sidewalks				
Barrier Type:	Cross Slope - Existing (4.1% to 4.9%)				
Code Ref:	CBC 1133B.7.1.3 and ADA/ABA 403.3

As Built Meas:	387	Quantity:	LF
Description:	Cross slope exceeds 2.0% (4.1% to 4.9%)		
As Built Desc:	4.6% cross slope		
Solution:	Demolish existing and construct new route		
Bar. Severity:	2 Recommended	Cost Estimate:	\$48,375.00
Implementation Priority:	2	Facility Function:	
Implementation Phase:		Implementation Date:	
Official Responsible:

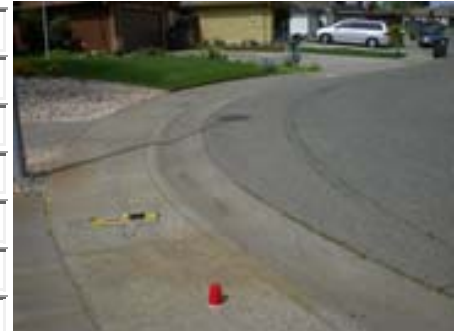
Field Date:	4/15/2011	Report Date:	4/15/2011	Barrier #:	6904
Location:	Sweet Gum Ct - West				
X Coordinate:	-121.26775				
Y Coordinate:	38.68727				
Barrier Area:	Sidewalks				
Barrier Type:	Cross Slope - Existing (4.1% to 4.9%)				
Code Ref:	CBC 1133B.7.1.3 and ADA/ABA 403.3

As Built Meas:	382	Quantity:	LF
Description:	Cross slope exceeds 2.0% (4.1% to 4.9%)		
As Built Desc:	4.3% cross slope		
Solution:	Demolish existing and construct new route		
Bar. Severity:	2 Recommended	Cost Estimate:	\$47,750.00
Implementation Priority:	2	Facility Function:	
Implementation Phase:		Implementation Date:	
Official Responsible:

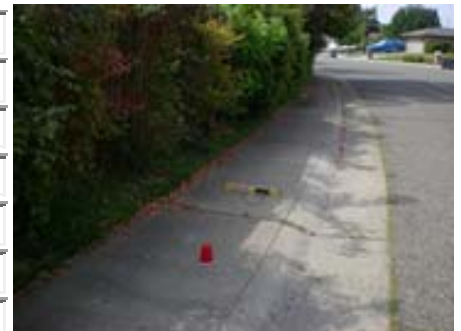
Field Date:	4/15/2011	Report Date:	4/15/2011	Barrier #:	6905
Location:	Larwin Dr - South				
X Coordinate:	-121.26895				
Y Coordinate:	38.68778				
Barrier Area:	Sidewalks				
Barrier Type:	Cross Slope - Existing (4.1% to 4.9%)				
Code Ref:	CBC 1133B.7.1.3 and ADA/ABA 403.3

As Built Meas:	273	Quantity:	LF
Description:	Cross slope exceeds 2.0% (4.1% to 4.9%)		
As Built Desc:	4.9% cross slope		
Solution:	Demolish existing and construct new route		
Bar. Severity:	2 Recommended	Cost Estimate:	\$34,125.00
Implementation Priority:	2	Facility Function:	
Implementation Phase:		Implementation Date:	
Official Responsible:

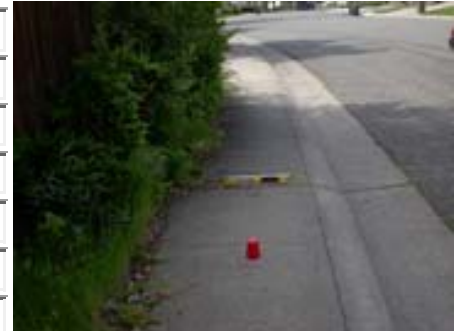
Field Date:	4/15/2011	Report Date:	4/15/2011	Barrier #:	6906
Location:	Larwin Dr - South				
X Coordinate:	-121.26915				
Y Coordinate:	38.68751				
Barrier Area:	Sidewalks				
Barrier Type:	Clear Width - Existing ($\leq 31"$ or less)				
Code Ref:	CBC 1133B.7.1

As Built Meas:	1	Quantity:	LF
Description:	Pedestrian route is not min. 48" wide ($\leq 31"$ or less)		
As Built Desc:	24" clear width due to foliage		
Solution:	Trim foliage to provide min. 48" clear width		
Bar. Severity:	1 Necessary	Cost Estimate:	\$125.00
Implementation Priority:	2	Facility Function:	
Implementation Phase:		Implementation Date:	
Official Responsible:			
Notes:

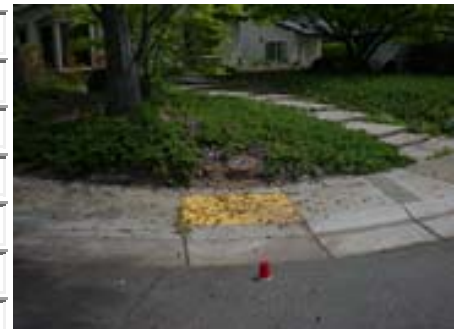
Field Date:	4/15/2011	Report Date:	4/15/2011	Barrier #:	6907A
Location:	Larwin Dr and Clear Creek Ct - Corner C				
X Coordinate:	-121.26933				
Y Coordinate:	38.68709				
Barrier Area:	Curb Ramps				
Barrier Type:	12" Grooves - Existing ($> 5.0\%$)				
Code Ref:	CBC 1127B.5.6

As Built Meas:	1	Quantity:	EACH
Description:	12" grooves at top of curb ramp are not level ($> 5.0\%$)		
As Built Desc:	5.9% at 12" grooves		
Solution:	Demolish existing and construct new curb ramp		
Bar. Severity:	1 Necessary	Cost Estimate:	\$2,500.00
Implementation Priority:	2	Facility Function:	
Implementation Phase:		Implementation Date:	
Official Responsible:			
Notes:	Four - way intersection corners A,B,C,D. Corners A,B,D compliant

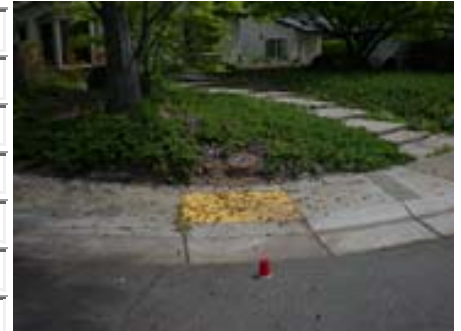
As Built Meas:	1	Quantity:	EACH
Description:	Curb ramp landing or pan not level (3.1% to 4.0%)		
As Built Desc:	3.4% landing slope		
Solution:	Demolish existing and construct new transition		
Bar. Severity:	3 Hindrance	Cost Estimate:	\$0.00
Implementation Priority:	2	Facility Function:	
Implementation Phase:		Implementation Date:	
Official Responsible:			
Notes:	Four - way intersection corners A,B,C,D. Corners A,B,D compliant

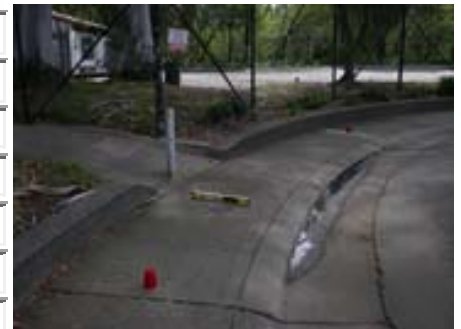
Field Date:	4/15/2011	Report Date:	4/15/2011	Barrier #:	6908
Location:	Clear Creek Ct - East				
X Coordinate:	-121.26861				
Y Coordinate:	38.68688				
Barrier Area:	Sidewalks				
Barrier Type:	Cross Slope - Existing (4.1% to 4.9%)				
Code Ref:	CBC 1133B.7.1.3 and ADA/ABA 403.3

As Built Meas:	23	Quantity:	LF
Description:	Cross slope exceeds 2.0% (4.1% to 4.9%)		
As Built Desc:	4.8% cross slope		
Solution:	Demolish existing and construct new route		
Bar. Severity:	2 Recommended	Cost Estimate:	\$2,875.00
Implementation Priority:	2	Facility Function:	
Implementation Phase:		Implementation Date:	
Official Responsible:			
Notes:

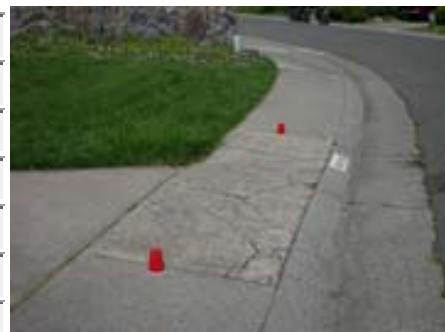
Field Date:	4/15/2011	Report Date:	4/15/2011	Barrier #:	6909
Location:	Clear Creek Ct - West				
X Coordinate:	-121.26884				
Y Coordinate:	38.6867				
Barrier Area:	Sidewalks				
Barrier Type:	Surface Condition - Damaged				
Code Ref:	CBC 1133B.7.1 and ADA/ABA 302.1

As Built Meas:	8	Quantity:	LF
Description:	Surface is not firm and stable (cracked, broken or loose soil, etc.)		
As Built Desc:	Cracked concrete		
Solution:	Repair surface to make firm and stable		
Bar. Severity:	1 Necessary	Cost Estimate:	\$1,000.00
Implementation Priority:	2	Facility Function:	
Implementation Phase:		Implementation Date:	
Official Responsible:			
Notes:

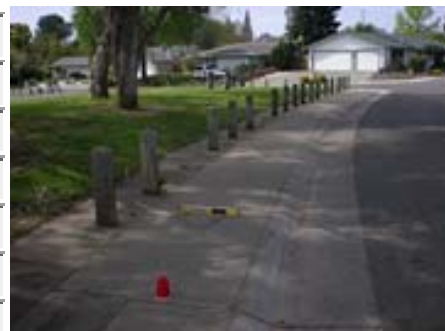
Field Date:	4/15/2011	Report Date:	4/15/2011	Barrier #:	6910
Location:	Larwin Dr - South				
X Coordinate:	-121.26965				
Y Coordinate:	38.68679				
Barrier Area:	Sidewalks				
Barrier Type:	Cross Slope - Existing (3.1% to 4.0%)				
Code Ref:	CBC 1133B.7.1.3 and ADA/ABA 403.3

As Built Meas:	90	Quantity:	LF
Description:	Cross slope exceeds 2.0% (3.1% to 4.0%)		
As Built Desc:	3.3% cross slope		
Solution:	Demolish existing and construct new route		
Bar. Severity:	3 Hindrance	Cost Estimate:	\$11,250.00
Implementation Priority:	2	Facility Function:	
Implementation Phase:		Implementation Date:	
Official Responsible:			
Notes:

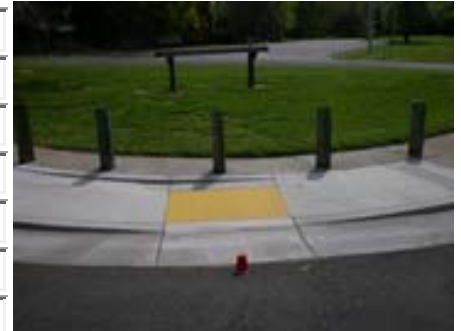
Field Date:	4/15/2011	Report Date:	4/15/2011	Barrier #:	6911
Location:	Larwin Dr and Smoke Tree Ct - Corner C				
X Coordinate:	-121.26992				
Y Coordinate:	38.68664				
Barrier Area:	Curb Ramps				
Barrier Type:	12" Grooves - Existing (4.1% to 4.9%)				
Code Ref:	CBC 1127B.5.6

As Built Meas:	1	Quantity:	EACH
Description:	12" grooves at top of curb ramp are not level (4.1% to 4.9%)		
As Built Desc:	4.1% at 12" grooves		
Solution:	Demolish existing and construct new curb ramp		
Bar. Severity:	2 Recommended	Cost Estimate:	\$2,500.00
Implementation Priority:	2	Facility Function:	
Implementation Phase:		Implementation Date:	
Official Responsible:

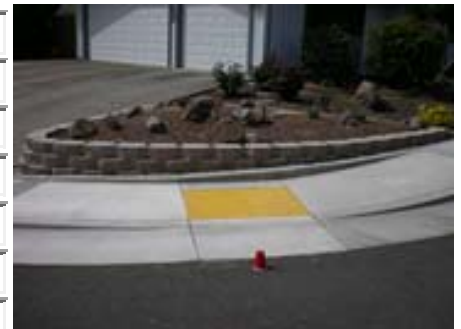
Field Date:	4/15/2011	Report Date:	4/15/2011	Barrier #:	6912
Location:	Larwin Dr and Smoke Tree Ct - Corner D				
X Coordinate:	-121.2701				
Y Coordinate:	38.68659				
Barrier Area:	Curb Ramps				
Barrier Type:	12" Grooves - Existing (4.1% to 4.9%)				
Code Ref:	CBC 1127B.5.6

As Built Meas:	1	Quantity:	EACH
Description:	12" grooves at top of curb ramp are not level (4.1% to 4.9%)		
As Built Desc:	4.1% at 12" grooves		
Solution:	Demolish existing and construct new curb ramp		
Bar. Severity:	2 Recommended	Cost Estimate:	\$2,500.00
Implementation Priority:	2	Facility Function:	
Implementation Phase:		Implementation Date:	
Official Responsible:

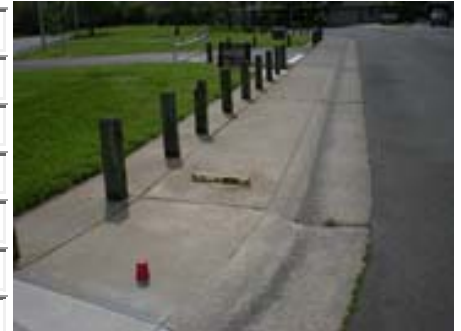
Field Date:	4/15/2011	Report Date:	4/15/2011	Barrier #:	6913
Location:	Smoke Tree Ct - East				
X Coordinate:	-121.2699				
Y Coordinate:	38.68659				
Barrier Area:	Sidewalks				
Barrier Type:	Cross Slope - Existing (3.1% to 4.0%)				
Code Ref:	CBC 1133B.7.1.3 and ADA/ABA 403.3

As Built Meas:	45	Quantity:	LF
Description:	Cross slope exceeds 2.0% (3.1% to 4.0%)		
As Built Desc:	3.9% cross slope		
Solution:	Demolish existing and construct new route		
Bar. Severity:	3 Hindrance	Cost Estimate:	\$5,625.00
Implementation Priority:	4	Facility Function:	
Implementation Phase:		Implementation Date:	
Official Responsible:

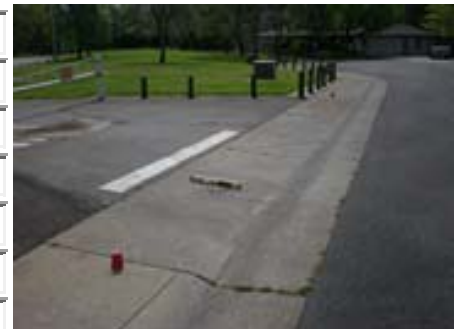
Field Date:	4/15/2011	Report Date:	4/15/2011	Barrier #:	6914
Location:	Smoke Tree Ct - East				
X Coordinate:	-121.26985				
Y Coordinate:	38.6865				
Barrier Area:	Sidewalks				
Barrier Type:	Driveway - Existing (5.0% or more)				
Code Ref:	CBC 1133B.7.1.3 and ADA/ABA 403.3

As Built Meas:	40	Quantity:	LF
Description:	Driveway cross slope exceeds 2.0% (5.0% or more)		
As Built Desc:	8.8% cross slope, 9.6% running slope		
Solution:	Provide min. 48" wide level walkway through driveway		
Bar. Severity:	1 Necessary	Cost Estimate:	\$5,000.00
Implementation Priority:	4	Facility Function:	
Implementation Phase:		Implementation Date:	
Official Responsible:

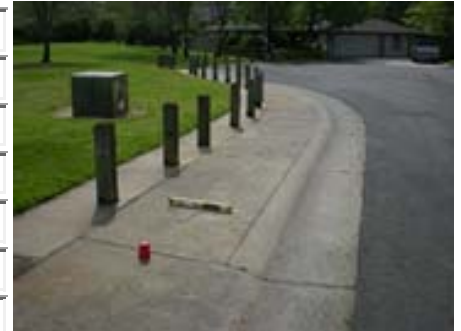
Field Date:	4/15/2011	Report Date:	4/15/2011	Barrier #:	6915
Location:	Smoke Tree Ct - East				
X Coordinate:	-121.26981				
Y Coordinate:	38.68639				
Barrier Area:	Sidewalks				
Barrier Type:	Cross Slope - Existing (3.1% to 4.0%)				
Code Ref:	CBC 1133B.7.1.3 and ADA/ABA 403.3

As Built Meas:	139	Quantity:	LF
Description:	Cross slope exceeds 2.0% (3.1% to 4.0%)		
As Built Desc:	4.0% cross slope		
Solution:	Demolish existing and construct new route		
Bar. Severity:	3 Hindrance	Cost Estimate:	\$17,375.00
Implementation Priority:	4	Facility Function:	
Implementation Phase:		Implementation Date:	
Official Responsible:			
Notes:

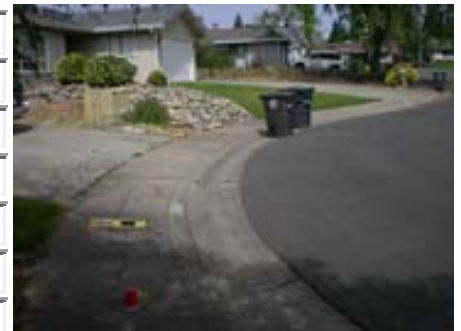
Field Date:	4/15/2011	Report Date:	4/15/2011	Barrier #:	6916
Location:	Smoke Tree Ct - West				
X Coordinate:	-121.26989				
Y Coordinate:	38.68606				
Barrier Area:	Sidewalks				
Barrier Type:	Cross Slope - Existing (3.1% to 4.0%)				
Code Ref:	CBC 1133B.7.1.3 and ADA/ABA 403.3

As Built Meas:	211	Quantity:	LF
Description:	Cross slope exceeds 2.0% (3.1% to 4.0%)		
As Built Desc:	3.9% cross slope		
Solution:	Demolish existing and construct new route		
Bar. Severity:	3 Hindrance	Cost Estimate:	\$26,375.00
Implementation Priority:	4	Facility Function:	
Implementation Phase:		Implementation Date:	
Official Responsible:			
Notes:

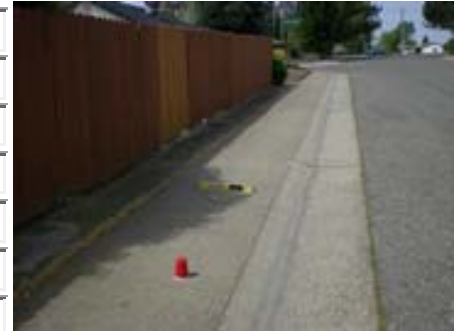
Field Date:	4/15/2011	Report Date:	4/15/2011	Barrier #:	6917
Location:	Larwin Dr - South				
X Coordinate:	-121.27051				
Y Coordinate:	38.68661				
Barrier Area:	Sidewalks				
Barrier Type:	Cross Slope - Existing (4.1% to 4.9%)				
Code Ref:	CBC 1133B.7.1.3 and ADA/ABA 403.3

As Built Meas:	112	Quantity:	LF
Description:	Cross slope exceeds 2.0% (4.1% to 4.9%)		
As Built Desc:	4.1% cross slope		
Solution:	Demolish existing and construct new route		
Bar. Severity:	2 Recommended	Cost Estimate:	\$14,000.00
Implementation Priority:	2	Facility Function:	
Implementation Phase:		Implementation Date:	
Official Responsible:

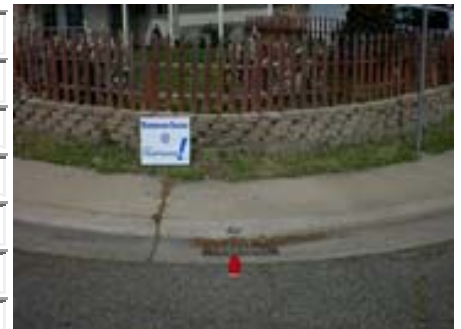
Field Date:	4/15/2011	Report Date:	4/15/2011	Barrier #:	6918
Location:	Larwin Dr and Sugar Maple Wy - Corner A				
X Coordinate:	-121.27104				
Y Coordinate:	38.68674				
Barrier Area:	Curb Ramps				
Barrier Type:	No Curb Ramp				
Code Ref:	CBC 1127B.5.1 and ADA/ABA 402.2

As Built Meas:	1	Quantity:	EACH
Description:	No curb cut at corner (intersection)		
As Built Desc:	No curb ramp at corner		
Solution:	Demolish existing and construct curb cut		
Bar. Severity:	1 Necessary	Cost Estimate:	\$2,500.00
Implementation Priority:	2	Facility Function:	
Implementation Phase:		Implementation Date:	
Official Responsible:

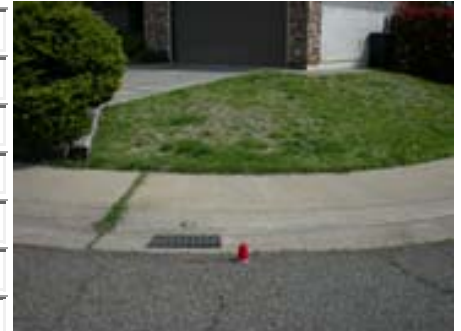
Barrier Type: No Curb Ramp

Code Ref: CBC 1127B.5.1 and ADA/ABA 402.2

As Built Meas: 1 Quantity: EACH

Description: No curb cut at corner (intersection)

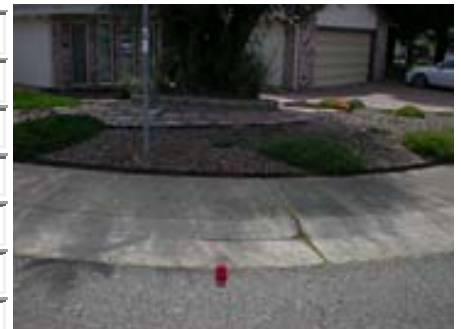
Barrier Type: No Curb Ramp

Code Ref: CBC 1127B.5.1 and ADA/ABA 402.2

As Built Meas: 1 Quantity: EACH

Description: No curb cut at corner (intersection)

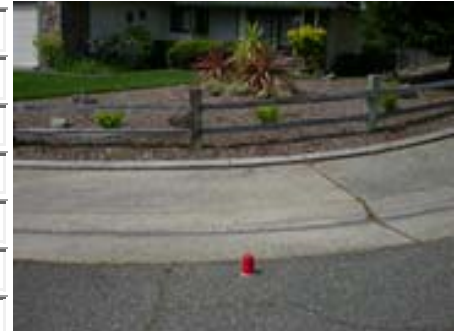
Field Date:	4/15/2011	Report Date:	4/15/2011	Barrier #:	6921
Location:	Larwin Dr and Sugar Maple Wy - Corner D				
X Coordinate:	-121.27102				
Y Coordinate:	38.68658				
Barrier Area:	Curb Ramps				
Barrier Type:	No Curb Ramp				
Code Ref:	CBC 1127B.5.1 and ADA/ABA 402.2

As Built Meas:	1	Quantity:	EACH
Description:	No curb cut at corner (intersection)		
As Built Desc:	No curb ramp at corner		
Solution:	Demolish existing and construct curb cut		
Bar. Severity:	1 Necessary	Cost Estimate:	\$2,500.00
Implementation Priority:	2	Facility Function:	
Implementation Phase:		Implementation Date:	
Official Responsible:			
Notes:	Four - way intersection corners A, B, C, D

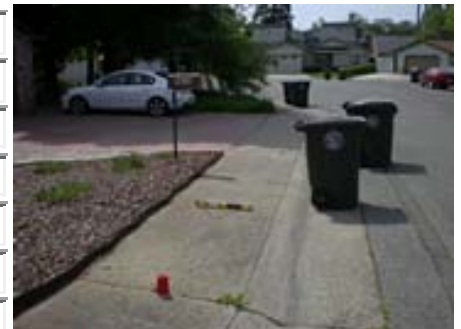
Field Date:	4/15/2011	Report Date:	4/15/2011	Barrier #:	6922
Location:	Golden Rain Ct - East				
X Coordinate:	-121.27089				
Y Coordinate:	38.68649				
Barrier Area:	Sidewalks				
Barrier Type:	Cross Slope - Existing (4.1% to 4.9%)				
Code Ref:	CBC 1133B.7.1.3 and ADA/ABA 403.3

As Built Meas:	212	Quantity:	LF
Description:	Cross slope exceeds 2.0% (4.1% to 4.9%)		
As Built Desc:	4.5% cross slope		
Solution:	Demolish existing and construct new route		
Bar. Severity:	2 Recommended	Cost Estimate:	\$26,500.00
Implementation Priority:	4	Facility Function:	
Implementation Phase:		Implementation Date:	
Official Responsible:			
Notes:

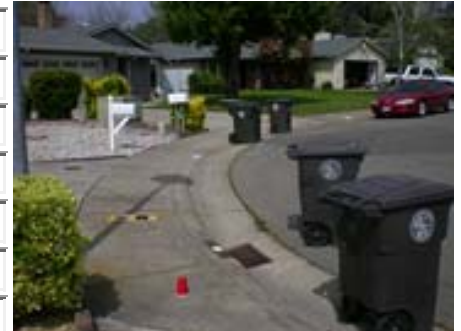
Field Date:	4/15/2011	Report Date:	4/15/2011	Barrier #:	6923
Location:	Golden Rain Ct - West				
X Coordinate:	-121.27094				
Y Coordinate:	38.68606				
Barrier Area:	Sidewalks				
Barrier Type:	Cross Slope - Existing (4.1% to 4.9%)				
Code Ref:	CBC 1133B.7.1.3 and ADA/ABA 403.3

As Built Meas:	194	Quantity:	LF
Description:	Cross slope exceeds 2.0% (4.1% to 4.9%)		
As Built Desc:	4.9% cross slope		
Solution:	Demolish existing and construct new route		
Bar. Severity:	2 Recommended	Cost Estimate:	\$24,250.00
Implementation Priority:	4	Facility Function:	
Implementation Phase:		Implementation Date:	
Official Responsible:

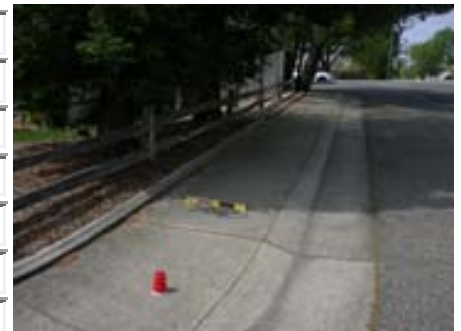
Field Date:	4/15/2011	Report Date:	4/15/2011	Barrier #:	6924A
Location:	Larwin Dr - South				
X Coordinate:	-121.27108				
Y Coordinate:	38.68659				
Barrier Area:	Sidewalks				
Barrier Type:	Cross Slope - Existing (5.0% or more)				
Code Ref:	CBC 1133B.7.1.3 and ADA/ABA 403.3

As Built Meas:	79	Quantity:	LF
Description:	Cross slope exceeds 2.0% (5.0% or more)		
As Built Desc:	5.9% cross slope		
Solution:	Demolish existing and construct new route		
Bar. Severity:	1 Necessary	Cost Estimate:	\$9,875.00
Implementation Priority:	2	Facility Function:	
Implementation Phase:		Implementation Date:	
Official Responsible:

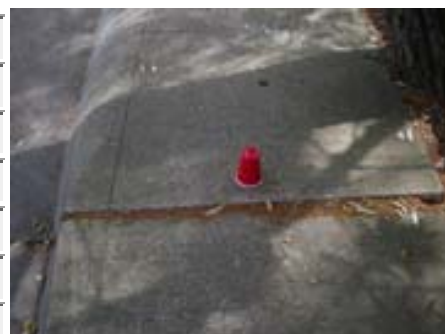
Field Date:	4/15/2011	Report Date:	4/15/2011	Barrier #:	6924B
Location:	Larwin Dr - South				
X Coordinate:	-121.27123				
Y Coordinate:	38.6866				
Barrier Area:	Sidewalks				
Barrier Type:	Abrupt Change in Level - Tree Heaves				
Code Ref:	CBC 1133B.7.1 and ADA/ABA 303.3

As Built Meas:	8	Quantity:	LF
Description:	Change in level greater than 1/2"		
As Built Desc:	1" lip due to tree heaves		
Solution:	Grind or repair sidewalk to remove trip hazard		
Bar. Severity:	1 Necessary	Cost Estimate:	\$2,000.00
Implementation Priority:	2	Facility Function:	
Implementation Phase:		Implementation Date:	
Official Responsible:			
Notes:

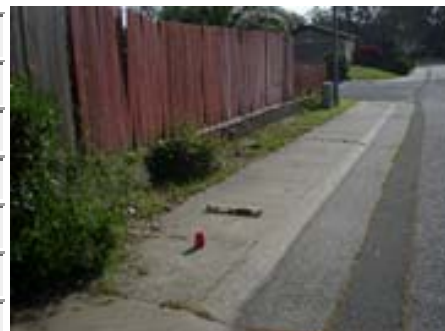
Field Date:	4/15/2011	Report Date:	4/15/2011	Barrier #:	6925
Location:	Larwin Dr - North				
X Coordinate:	-121.27144				
Y Coordinate:	38.68669				
Barrier Area:	Sidewalks				
Barrier Type:	Cross Slope - Existing (3.1% to 4.0%)				
Code Ref:	CBC 1133B.7.1.3 and ADA/ABA 403.3

As Built Meas:	84	Quantity:	LF
Description:	Cross slope exceeds 2.0% (3.1% to 4.0%)		
As Built Desc:	3.8% cross slope		
Solution:	Demolish existing and construct new route		
Bar. Severity:	3 Hindrance	Cost Estimate:	\$10,500.00
Implementation Priority:	2	Facility Function:	
Implementation Phase:		Implementation Date:	
Official Responsible:			
Notes:

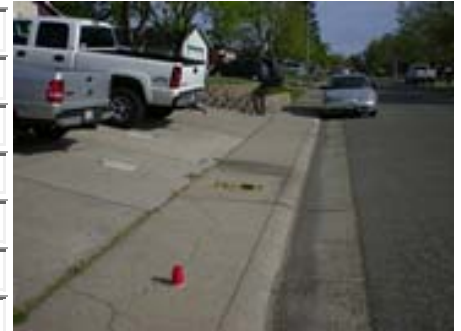
Barrier Type: Cross Slope - Existing (4.1% to 4.9%)

Code Ref: CBC 1133B.7.1.3 and ADA/ABA 403.3

As Built Meas: 705 Quantity: LF

Description: Cross slope exceeds 2.0% (4.1% to 4.9%)

Bar. Severity: 2 Recommended Cost Estimate: \$88,125.00 Status:

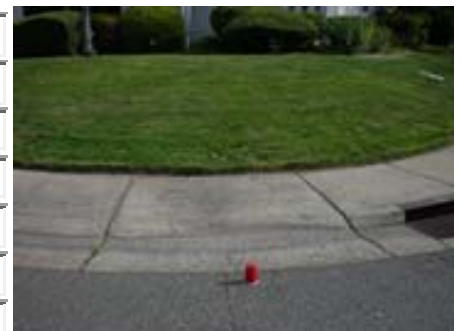
Barrier Type: No Curb Ramp - Depressed Existing Curb

Code Ref: CBC 1127B.5.1 and ADA/ABA 402.2

As Built Meas: 1 Quantity: EACH

Description: No compliant curb cut at corner (intersection)

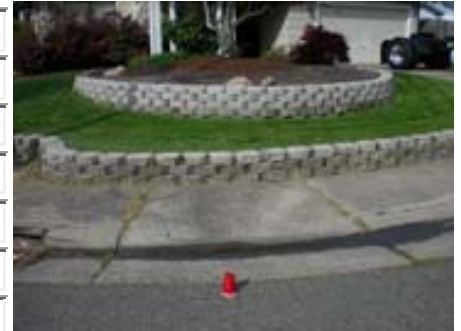
Field Date:	4/15/2011	Report Date:	4/15/2011	Barrier #:	6928
Location:	Sugar Maple Wy and Sugar Maple Wy Ct - Corner D				
X Coordinate:	-121.27071				
Y Coordinate:	38.68879				
Barrier Area:	Curb Ramps				
Barrier Type:	No Curb Ramp - Depressed Existing Curb				
Code Ref:	CBC 1127B.5.1 and ADA/ABA 402.2

As Built Meas:	1	Quantity:	EACH
Description:	No compliant curb cut at corner (intersection)		
As Built Desc:	10.2% running slope at depressed area		
Solution:	Demolish existing and construct curb cut		
Bar. Severity:	1 Necessary	Cost Estimate:	\$2,500.00
Implementation Priority:	4	Facility Function:	
Implementation Phase:		Implementation Date:	
Official Responsible:			
Notes:	Two - way intersection corners A,D
