DRAFT ADA TRANSITION PLAN UPDATE
NEIGHBORHOOD AREA 9 SONA
SEPTEMBER 20, 2011

CITY OF CITRUS HEIGHTS

The Sunrise Oaks Neighborhood Association (SONA)

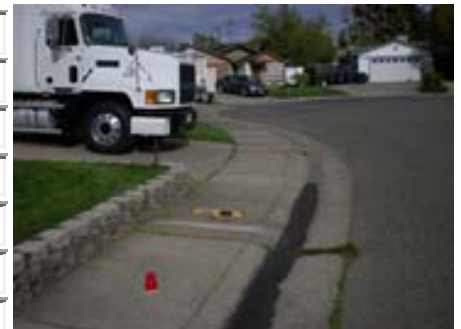
Field Date:	4/15/2011	Report Date:	4/15/2011	Barrier #:	6929
Location:	Sugar Maple Wy Ct - South				
X Coordinate:	-121.27077				
Y Coordinate:	38.68881				
Barrier Area:	Sidewalks				
Barrier Type:	Cross Slope - New Construction				
Code Ref:	CBC 1133B.7.1.3 and ADA/ABA 403.3

As Built Meas:	165	Quantity:	LF
Description:	Cross slope exceeds 2.0% in new construction		
As Built Desc:	2.8% cross slope		
Solution:	Demolish existing and construct new route		
Bar. Severity:	1 Necessary	Cost Estimate:	\$20,625.00
Implementation Priority:	4	Facility Function:	
Implementation Phase:		Implementation Date:	
Official Responsible:			
Notes:

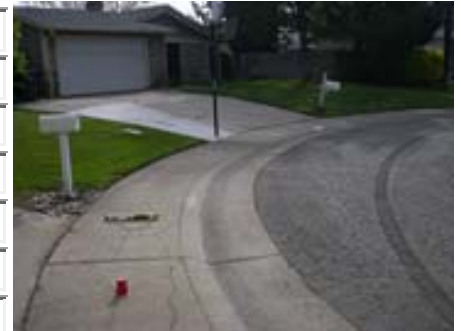
Field Date:	4/15/2011	Report Date:	4/15/2011	Barrier #:	6930
Location:	Sugar Maple Wy Ct - North				
X Coordinate:	-121.27093				
Y Coordinate:	38.68911				
Barrier Area:	Sidewalks				
Barrier Type:	Cross Slope - Existing (2.1% to 3.0%)				
Code Ref:	CBC 1133B.7.1.3 and ADA/ABA 403.3

As Built Meas:	147	Quantity:	LF
Description:	Cross slope exceeds 2.0% (2.1% to 3.0%)		
As Built Desc:	4.2% cross slope		
Solution:	Low severity barrier - no remediation recommended		
Bar. Severity:	4 Low Severity	Cost Estimate:	\$0.00
Implementation Priority:	4	Facility Function:	
Implementation Phase:		Implementation Date:	
Official Responsible:

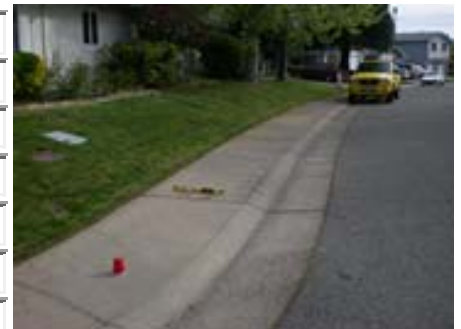
Field Date:	4/15/2011	Report Date:	4/15/2011	Barrier #:	6931
Location:	Larwin Dr - North				
X Coordinate:	-121.27056				
Y Coordinate:	38.68885				
Barrier Area:	Sidewalks				
Barrier Type:	Cross Slope - Existing (4.1% to 4.9%)				
Code Ref:	CBC 1133B.7.1.3 and ADA/ABA 403.3

As Built Meas:	554	Quantity:	LF
Description:	Cross slope exceeds 2.0% (4.1% to 4.9%)		
As Built Desc:	4.5% cross slope		
Solution:	Demolish existing and construct new route		
Bar. Severity:	2 Recommended	Cost Estimate:	\$69,250.00
Implementation Priority:	2	Facility Function:	
Implementation Phase:		Implementation Date:	
Official Responsible:

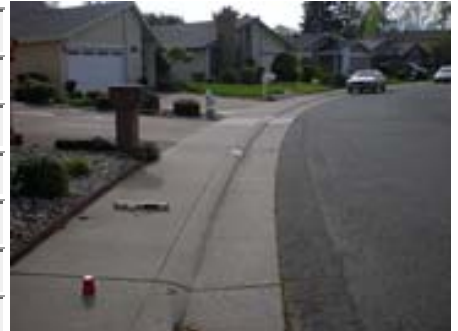
Field Date:	4/15/2011	Report Date:	4/15/2011	Barrier #:	6932
Location:	Larwin Dr - East				
X Coordinate:	-121.26873				
Y Coordinate:	38.68905				
Barrier Area:	Sidewalks				
Barrier Type:	Cross Slope - Existing (3.1% to 4.0%)				
Code Ref:	CBC 1133B.7.1.3 and ADA/ABA 403.3

As Built Meas:	300	Quantity:	LF
Description:	Cross slope exceeds 2.0% (3.1% to 4.0%)		
As Built Desc:	3.8% cross slope		
Solution:	Demolish existing and construct new route		
Bar. Severity:	3 Hindrance	Cost Estimate:	\$37,500.00
Implementation Priority:	2	Facility Function:	
Implementation Phase:		Implementation Date:	
Official Responsible:

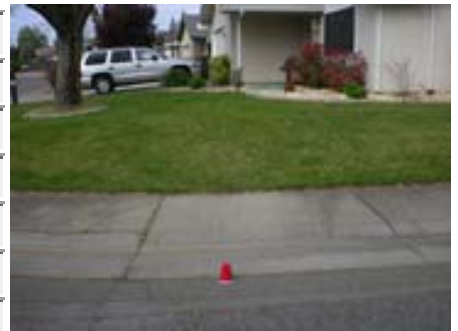
Field Date:	4/15/2011	Report Date:	4/15/2011	Barrier #:	6933
Location:	Larwin Dr and Sugar Maple Wy - Corner A				
X Coordinate:	-121.26832				
Y Coordinate:	38.68835				
Barrier Area:	Curb Ramps				
Barrier Type:	No Curb Ramp - Depressed Existing Curb				
Code Ref:	CBC 1127B.5.1 and ADA/ABA 402.2

As Built Meas:	1	Quantity:	EACH
Description:	No compliant curb cut at corner (intersection)		
As Built Desc:	10.2% running slope at depressed area		
Solution:	Demolish existing and construct curb cut		
Bar. Severity:	1 Necessary	Cost Estimate:	\$2,500.00
Implementation Priority:	2	Facility Function:	
Implementation Phase:		Implementation Date:	
Official Responsible:

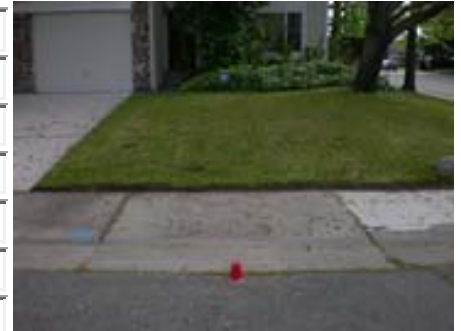
Field Date:	4/15/2011	Report Date:	4/15/2011	Barrier #:	6934
Location:	Larwin Dr and Sugar Maple Wy - Corner B				
X Coordinate:	-121.26815				
Y Coordinate:	38.68838				
Barrier Area:	Curb Ramps				
Barrier Type:	No Curb Ramp - Depressed Existing Curb				
Code Ref:	CBC 1127B.5.1 and ADA/ABA 402.2

As Built Meas:	1	Quantity:	EACH
Description:	No compliant curb cut at corner (intersection)		
As Built Desc:	8.6% running slope at depressed area		
Solution:	Demolish existing and construct curb cut		
Bar. Severity:	1 Necessary	Cost Estimate:	\$2,500.00
Implementation Priority:	2	Facility Function:	
Implementation Phase:		Implementation Date:	
Official Responsible:			
Notes:	Two - way intersection corners A,B

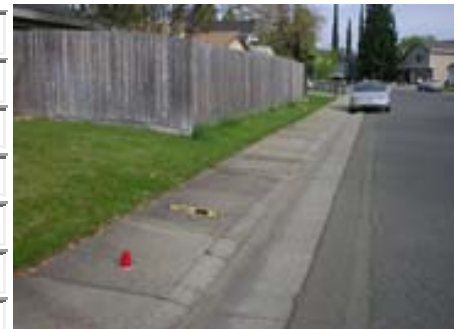
Field Date:	4/15/2011	Report Date:	4/15/2011	Barrier #:	6935
Location:	Sugar Maple Wy - West				
X Coordinate:	-121.2684				
Y Coordinate:	38.68847				
Barrier Area:	Sidewalks				
Barrier Type:	Cross Slope - Existing (4.1% to 4.9%)				
Code Ref:	CBC 1133B.7.1.3 and ADA/ABA 403.3

As Built Meas:	354	Quantity:	LF
Description:	Cross slope exceeds 2.0% (4.1% to 4.9%)		
As Built Desc:	4.3% cross slope		
Solution:	Demolish existing and construct new route		
Bar. Severity:	2 Recommended	Cost Estimate:	\$44,250.00
Implementation Priority:	4	Facility Function:	
Implementation Phase:		Implementation Date:	
Official Responsible:			
Notes:

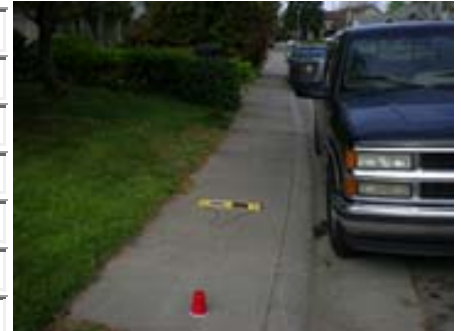
Field Date:	4/15/2011	Report Date:	4/15/2011	Barrier #:	6936
Location:	Sugar Maple Wy - South				
X Coordinate:	-121.26906				
Y Coordinate:	38.68904				
Barrier Area:	Sidewalks				
Barrier Type:	Cross Slope - Existing (4.1% to 4.9%)				
Code Ref:	CBC 1133B.7.1.3 and ADA/ABA 403.3

As Built Meas:	610	Quantity:	LF
Description:	Cross slope exceeds 2.0% (4.1% to 4.9%)		
As Built Desc:	4.8% cross slope		
Solution:	Demolish existing and construct new route		
Bar. Severity:	2 Recommended	Cost Estimate:	\$76,250.00
Implementation Priority:	4	Facility Function:	
Implementation Phase:		Implementation Date:	
Official Responsible:

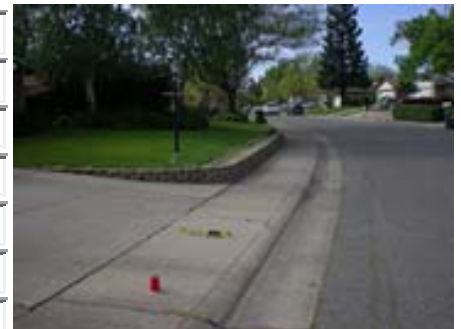
Field Date:	4/15/2011	Report Date:	4/15/2011	Barrier #:	6937A
Location:	Sugar Maple Wy - East				
X Coordinate:	-121.27079				
Y Coordinate:	38.68836				
Barrier Area:	Sidewalks				
Barrier Type:	Cross Slope - Existing (3.1% to 4.0%)				
Code Ref:	CBC 1133B.7.1.3 and ADA/ABA 403.3

As Built Meas:	527	Quantity:	LF
Description:	Cross slope exceeds 2.0% (3.1% to 4.0%)		
As Built Desc:	4.0% cross slope		
Solution:	Demolish existing and construct new route		
Bar. Severity:	3 Hindrance	Cost Estimate:	\$65,875.00
Implementation Priority:	4	Facility Function:	
Implementation Phase:		Implementation Date:	
Official Responsible:

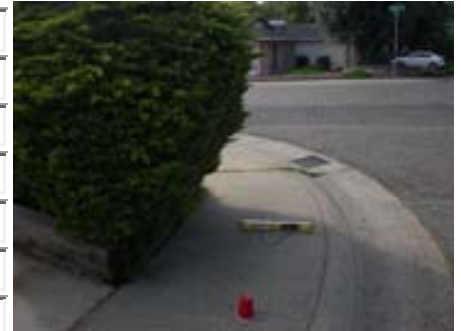
Field Date:	4/15/2011	Report Date:	4/15/2011	Barrier #:	6937B
Location:	Sugar Maple Wy - East				
X Coordinate:	-121.27083				
Y Coordinate:	38.68682				
Barrier Area:	Sidewalks				
Barrier Type:	Clear Width - Existing ($\leq 31"$ or less)				
Code Ref:	CBC 1133B.7.1

As Built Meas:	1	Quantity:	LF
Description:	Pedestrian route is not min. 48" wide ($\leq 31"$ or less)		
As Built Desc:	30" clear width due to foliage		
Solution:	Trim foliage to provide min. 48" clear width		
Bar. Severity:	1 Necessary	Cost Estimate:	\$125.00
Implementation Priority:	4	Facility Function:	
Implementation Phase:		Implementation Date:	
Official Responsible:

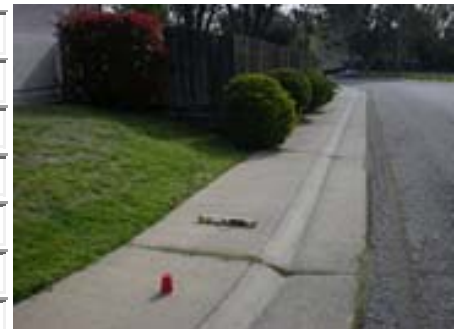
Field Date:	4/15/2011	Report Date:	4/15/2011	Barrier #:	6938A
Location:	Larwin Dr - North				
X Coordinate:	-121.27082				
Y Coordinate:	38.68674				
Barrier Area:	Sidewalks				
Barrier Type:	Cross Slope - Existing (3.1% to 4.0%)				
Code Ref:	CBC 1133B.7.1.3 and ADA/ABA 403.3

As Built Meas:	369	Quantity:	LF
Description:	Cross slope exceeds 2.0% (3.1% to 4.0%)		
As Built Desc:	4.0% cross slope		
Solution:	Demolish existing and construct new route		
Bar. Severity:	3 Hindrance	Cost Estimate:	\$46,125.00
Implementation Priority:	2	Facility Function:	
Implementation Phase:		Implementation Date:	
Official Responsible:

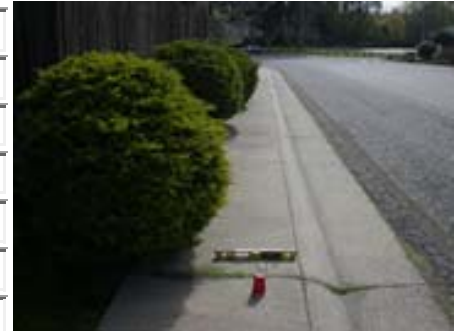
Field Date:	4/15/2011	Report Date:	4/15/2011	Barrier #:	6938B
Location:	Larwin Dr - North				
X Coordinate:	-121.27073				
Y Coordinate:	38.68674				
Barrier Area:	Sidewalks				
Barrier Type:	Clear Width - Existing ($\leq 31"$ or less)				
Code Ref:	CBC 1133B.7.1

As Built Meas:	1	Quantity:	LF
Description:	Pedestrian route is not min. 48" wide ($\leq 31"$ or less)		
As Built Desc:	24" clear width due to foliage		
Solution:	Trim foliage to provide min. 48" clear width		
Bar. Severity:	1 Necessary	Cost Estimate:	\$125.00
Implementation Priority:	2	Facility Function:	
Implementation Phase:		Implementation Date:	
Official Responsible:			
Notes:

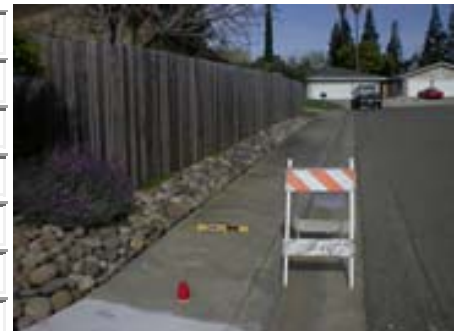
Field Date:	4/15/2011	Report Date:	4/15/2011	Barrier #:	6939
Location:	Green Ash Ct - West				
X Coordinate:	-121.26967				
Y Coordinate:	38.68713				
Barrier Area:	Sidewalks				
Barrier Type:	Cross Slope - Existing (3.1% to 4.0%)				
Code Ref:	CBC 1133B.7.1.3 and ADA/ABA 403.3

As Built Meas:	187	Quantity:	LF
Description:	Cross slope exceeds 2.0% (3.1% to 4.0%)		
As Built Desc:	3.7% cross slope		
Solution:	Demolish existing and construct new route		
Bar. Severity:	3 Hindrance	Cost Estimate:	\$23,375.00
Implementation Priority:	4	Facility Function:	
Implementation Phase:		Implementation Date:	
Official Responsible:			
Notes:

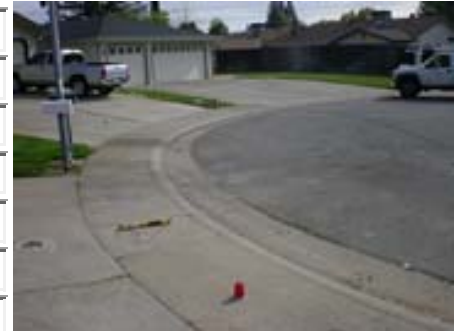
Field Date: 4/15/2011 Report Date: 4/15/2011 Barrier #: 6940

Barrier Type: Cross Slope - Existing (4.1% to 4.9%)

As Built Meas: 226 Quantity: LF

Description: Cross slope exceeds 2.0% (4.1% to 4.9%)

Bar. Severity: 2 Recommended Cost Estimate: \$28,250.00 Status:

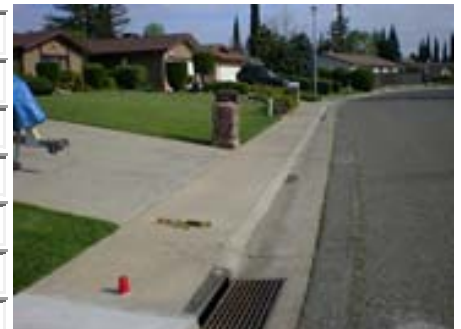
Barrier Type: Cross Slope - Existing (3.1% to 4.0%)

As Built Meas: 125 Quantity: LF

Description: Cross slope exceeds 2.0% (3.1% to 4.0%)

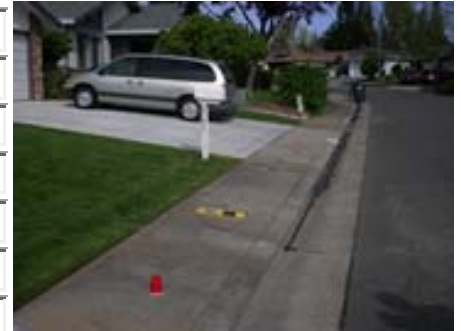
Field Date:	4/15/2011	Report Date:	4/15/2011	Barrier #:	6942
Location:	Canoe Birch Ct - West				
X Coordinate:	-121.26901				
Y Coordinate:	38.68802				
Barrier Area:	Sidewalks				
Barrier Type:	Cross Slope - Existing (3.1% to 4.0%)				
Code Ref:	CBC 1133B.7.1.3 and ADA/ABA 403.3

As Built Meas:	221	Quantity:	LF
Description:	Cross slope exceeds 2.0% (3.1% to 4.0%)		
As Built Desc:	3.5% cross slope		
Solution:	Demolish existing and construct new route		
Bar. Severity:	3 Hindrance	Cost Estimate:	\$27,625.00
Implementation Priority:	4	Facility Function:	
Implementation Phase:		Implementation Date:	
Official Responsible:

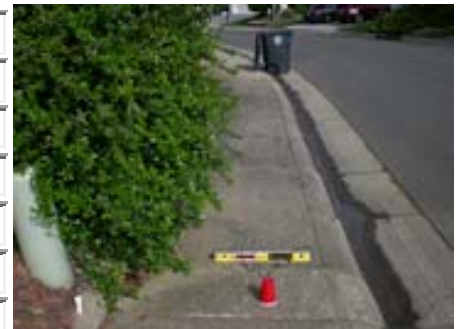
Field Date:	4/15/2011	Report Date:	4/15/2011	Barrier #:	6943
Location:	Canoe Birch Ct - West				
X Coordinate:	-121.26913				
Y Coordinate:	38.68809				
Barrier Area:	Sidewalks				
Barrier Type:	Clear Width - Existing ($\leq 31"$ or less)				
Code Ref:	CBC 1133B.7.1

As Built Meas:	1	Quantity:	LF
Description:	Pedestrian route is not min. 48" wide ($\leq 31"$ or less)		
As Built Desc:	24" clear width due to foliage		
Solution:	Trim foliage to provide min. 48" clear width		
Bar. Severity:	1 Necessary	Cost Estimate:	\$125.00
Implementation Priority:	4	Facility Function:	
Implementation Phase:		Implementation Date:	
Official Responsible:

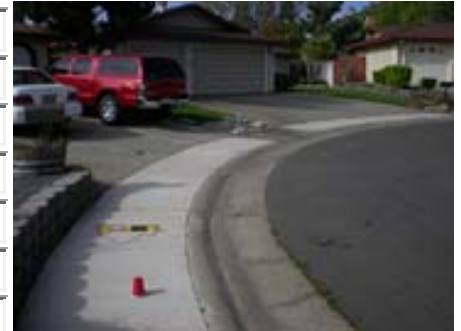
Field Date:	4/15/2011	Report Date:	4/15/2011	Barrier #:	6944
Location:	Canoe Birch Ct - West				
X Coordinate:	-121.26981				
Y Coordinate:	38.68817				
Barrier Area:	Sidewalks				
Barrier Type:	Cross Slope - Existing (5.0% or more)				
Code Ref:	CBC 1133B.7.1.3 and ADA/ABA 403.3

As Built Meas:	94	Quantity:	LF
Description:	Cross slope exceeds 2.0% (5.0% or more)		
As Built Desc:	5.6% cross slope		
Solution:	Demolish existing and construct new route		
Bar. Severity:	1 Necessary	Cost Estimate:	\$11,750.00
Implementation Priority:	4	Facility Function:	
Implementation Phase:		Implementation Date:	
Official Responsible:

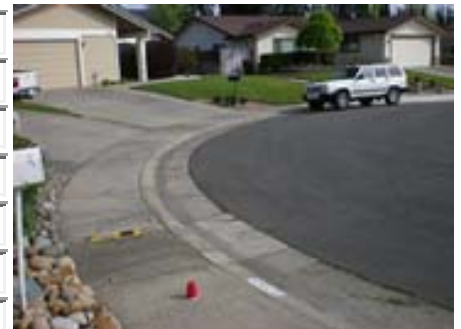
Field Date:	4/15/2011	Report Date:	4/15/2011	Barrier #:	6945
Location:	Canoe Birch Ct - East				
X Coordinate:	-121.27009				
Y Coordinate:	38.68817				
Barrier Area:	Sidewalks				
Barrier Type:	Cross Slope - Existing (4.1% to 4.9%)				
Code Ref:	CBC 1133B.7.1.3 and ADA/ABA 403.3

As Built Meas:	405	Quantity:	LF
Description:	Cross slope exceeds 2.0% (4.1% to 4.9%)		
As Built Desc:	4.8% cross slope		
Solution:	Demolish existing and construct new route		
Bar. Severity:	2 Recommended	Cost Estimate:	\$50,625.00
Implementation Priority:	4	Facility Function:	
Implementation Phase:		Implementation Date:	
Official Responsible:

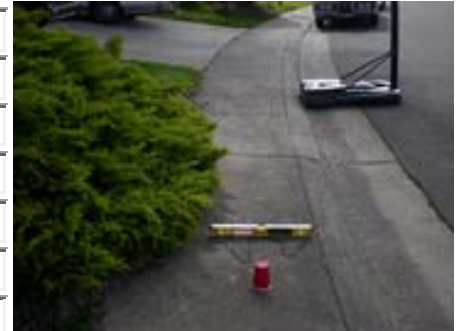
Field Date:	4/15/2011	Report Date:	4/15/2011	Barrier #:	6946
Location:	Canoe Birch Ct - East				
X Coordinate:	-121.26935				
Y Coordinate:	38.68839				
Barrier Area:	Sidewalks				
Barrier Type:	Clear Width - Existing ($\leq 31"$ or less)				
Code Ref:	CBC 1133B.7.1

As Built Meas:	1	Quantity:	LF
Description:	Pedestrian route is not min. 48" wide ($\leq 31"$ or less)		
As Built Desc:	24" clear width due to foliage		
Solution:	Trim foliage to provide min. 48" clear width		
Bar. Severity:	1 Necessary	Cost Estimate:	\$125.00
Implementation Priority:	4	Facility Function:	
Implementation Phase:		Implementation Date:	
Official Responsible:			
Notes:

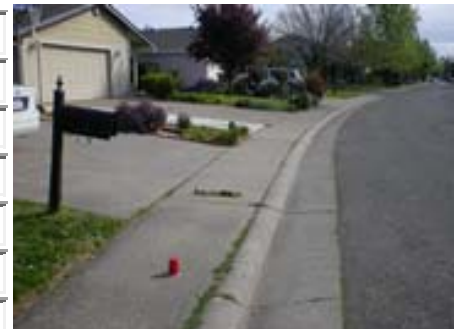
Field Date:	4/15/2011	Report Date:	4/15/2011	Barrier #:	6947
Location:	Larwin Dr - North				
X Coordinate:	-121.26879				
Y Coordinate:	38.68808				
Barrier Area:	Sidewalks				
Barrier Type:	Cross Slope - Existing (4.1% to 4.9%)				
Code Ref:	CBC 1133B.7.1.3 and ADA/ABA 403.3

As Built Meas:	159	Quantity:	LF
Description:	Cross slope exceeds 2.0% (4.1% to 4.9%)		
As Built Desc:	4.5% cross slope		
Solution:	Demolish existing and construct new route		
Bar. Severity:	2 Recommended	Cost Estimate:	\$19,875.00
Implementation Priority:	2	Facility Function:	
Implementation Phase:		Implementation Date:	
Official Responsible:			
Notes:

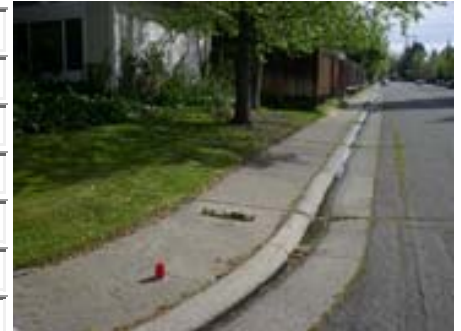
Field Date:	4/15/2011	Report Date:	4/15/2011	Barrier #:	6948
Location:	Larwin Dr - North				
X Coordinate:	-121.26799				
Y Coordinate:	38.68835				
Barrier Area:	Sidewalks				
Barrier Type:	Cross Slope - Existing (3.1% to 4.0%)				
Code Ref:	CBC 1133B.7.1.3 and ADA/ABA 403.3

As Built Meas:	200	Quantity:	LF
Description:	Cross slope exceeds 2.0% (3.1% to 4.0%)		
As Built Desc:	3.3% cross slope		
Solution:	Demolish existing and construct new route		
Bar. Severity:	3 Hindrance	Cost Estimate:	\$25,000.00
Implementation Priority:	2	Facility Function:	
Implementation Phase:		Implementation Date:	
Official Responsible:

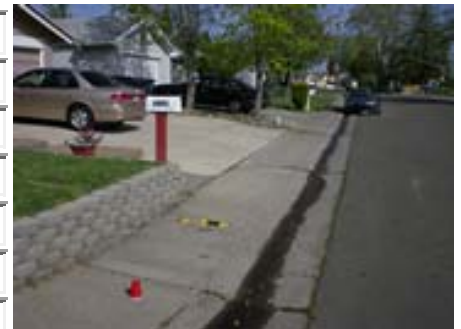
Field Date:	4/15/2011	Report Date:	4/15/2011	Barrier #:	6949
Location:	Olive Tree Wy Ct - West				
X Coordinate:	-121.26748				
Y Coordinate:	38.68857				
Barrier Area:	Sidewalks				
Barrier Type:	Cross Slope - Existing (3.1% to 4.0%)				
Code Ref:	CBC 1133B.7.1.3 and ADA/ABA 403.3

As Built Meas:	1034	Quantity:	LF
Description:	Cross slope exceeds 2.0% (3.1% to 4.0%)		
As Built Desc:	3.8% cross slope		
Solution:	Demolish existing and construct new route		
Bar. Severity:	3 Hindrance	Cost Estimate:	\$129,250.00
Implementation Priority:	4	Facility Function:	
Implementation Phase:		Implementation Date:	
Official Responsible:

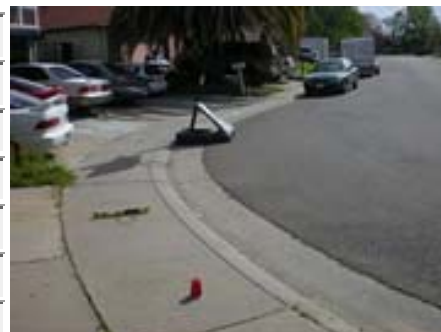
Field Date:	4/15/2011	Report Date:	4/15/2011	Barrier #:	6950
Location:	Olive Tree Wy - North				
X Coordinate:	-121.2679				
Y Coordinate:	38.69131				
Barrier Area:	Sidewalks				
Barrier Type:	Cross Slope - Existing (4.1% to 4.9%)				
Code Ref:	CBC 1133B.7.1.3 and ADA/ABA 403.3

As Built Meas:	289	Quantity:	LF
Description:	Cross slope exceeds 2.0% (4.1% to 4.9%)		
As Built Desc:	4.5% cross slope		
Solution:	Demolish existing and construct new route		
Bar. Severity:	2 Recommended	Cost Estimate:	\$36,125.00
Implementation Priority:	4	Facility Function:	
Implementation Phase:		Implementation Date:	
Official Responsible:			
Notes:

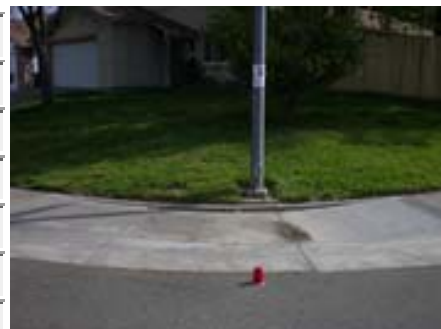
Field Date:	4/15/2011	Report Date:	4/15/2011	Barrier #:	6951A
Location:	Olive Tree Wy and Red Maple Wy - Corner B				
X Coordinate:	-121.26683				
Y Coordinate:	38.69127				
Barrier Area:	Curb Ramps				
Barrier Type:	12" Grooves - Existing (2.1% to 3.0%)				
Code Ref:	CBC 1127B.5.6

As Built Meas:	1	Quantity:	EACH
Description:	12" grooves at top of curb ramp are not level (2.1% to 3.0%)		
As Built Desc:	2.9% at 12" grooves		
Solution:	Demolish existing and construct new curb ramp		
Bar. Severity:	4 Low Severity	Cost Estimate:	\$2,500.00
Implementation Priority:	4	Facility Function:	
Implementation Phase:		Implementation Date:	
Official Responsible:			
Notes:	Four - way intersection corners A,B,C,D. Corners A,D compliant

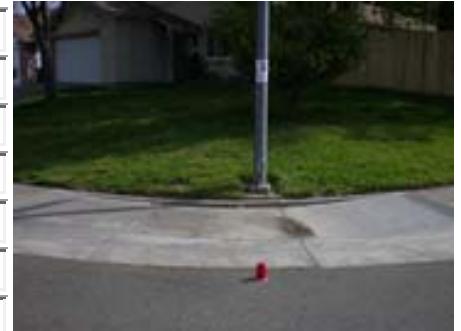
As Built Meas:	1	Quantity:	EACH
Description:	No truncated domes provided at curb ramp		
As Built Desc:	No detectable warnings at curb ramp		
Solution:	Provide compliant truncated domes		
Bar. Severity:	2 Recommended	Cost Estimate:	\$0.00
Implementation Priority:	4	Facility Function:	
Implementation Phase:		Implementation Date:	
Official Responsible:			
Notes:	Four - way intersection corners A,B,C,D. Corners A,D compliant

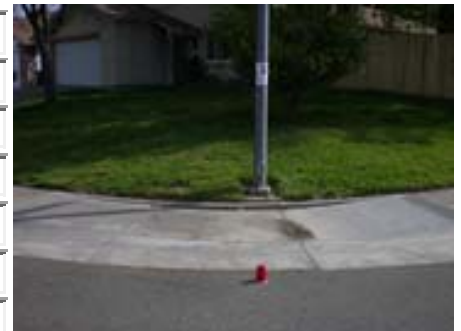
As Built Meas:	6	Quantity:	SF
Description:	Gutter slope exceeds 5.0% (8.3% or more)		
As Built Desc:	9.8% gutter slope		
Solution:	Demolish existing and construct new gutter		
Bar. Severity:	1 Necessary	Cost Estimate:	\$0.00
Implementation Priority:	4	Facility Function:	
Implementation Phase:		Implementation Date:	
Official Responsible:			
Notes:	Four - way intersection corners A,B,C,D. Corners A,D compliant

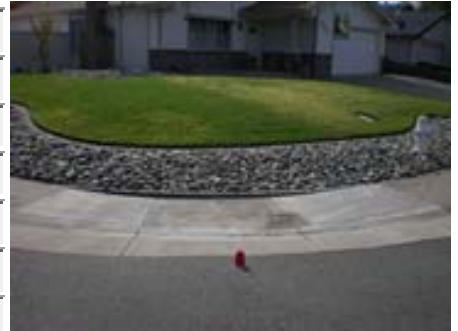
Field Date:	4/15/2011	Report Date:	4/15/2011	Barrier #:	6952A
Location:	Olive Tree Wy and Red Maple Wy - Corner C				
X Coordinate:	-121.26679				
Y Coordinate:	38.69115				
Barrier Area:	Curb Ramps				
Barrier Type:	12" Grooves - Existing (3.1% to 4.0%)				
Code Ref:	CBC 1127B.5.6

As Built Meas:	1	Quantity:	EACH
Description:	12" grooves at top of curb ramp are not level (3.1% to 4.0%)		
As Built Desc:	3.5% at 12" grooves		
Solution:	Demolish existing and construct new curb ramp		
Bar. Severity:	3 Hindrance	Cost Estimate:	\$2,500.00
Implementation Priority:	4	Facility Function:	
Implementation Phase:		Implementation Date:	
Official Responsible:

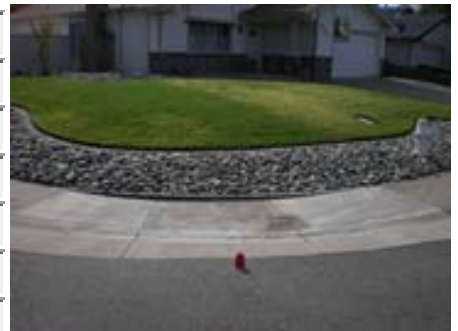
Field Date:	4/15/2011	Report Date:	4/15/2011	Barrier #:	6952B
Location:	Olive Tree Wy and Red Maple Wy - Corner C				
X Coordinate:	-121.26679				
Y Coordinate:	38.69115				
Barrier Area:	Curb Ramps				
Barrier Type:	Detectable Warnings - Truncated Domes				
Code Ref:	CBC 1127B.5.7 and ADA/ABA 705.1.3

As Built Meas:	1	Quantity:	EACH
Description:	No truncated domes provided at curb ramp		
As Built Desc:	No detectable warnings at curb ramp		
Solution:	Provide compliant truncated domes		
Bar. Severity:	2 Recommended	Cost Estimate:	\$0.00
Implementation Priority:	4	Facility Function:	
Implementation Phase:		Implementation Date:	
Official Responsible:

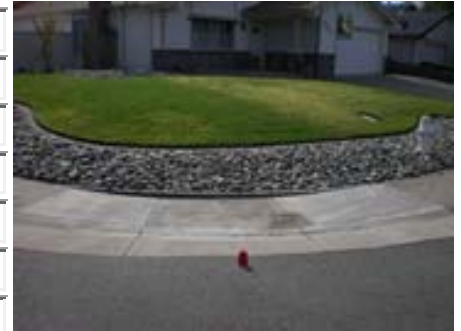
Field Date:	4/15/2011	Report Date:	4/15/2011	Barrier #:	6952C
Location:	Olive Tree Wy and Red Maple Wy - Corner C				
X Coordinate:	-121.26679				
Y Coordinate:	38.69115				
Barrier Area:	Curb Ramps				
Barrier Type:	Gutter Slope - Existing (8.3% or more)				
Code Ref:	CBC 1127B.5.3 and ADA/ABA 406.2

As Built Meas:	6	Quantity:	SF
Description:	Gutter slope exceeds 5.0% (8.3% or more)		
As Built Desc:	10.5% gutter slope		
Solution:	Demolish existing and construct new gutter		
Bar. Severity:	1 Necessary	Cost Estimate:	\$0.00
Implementation Priority:	4	Facility Function:	
Implementation Phase:		Implementation Date:	
Official Responsible:

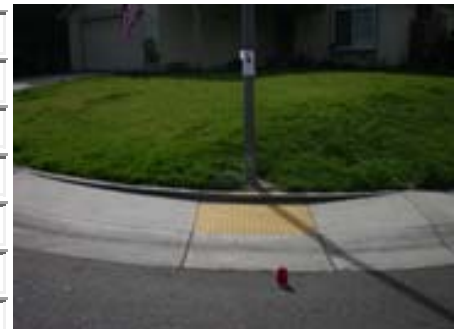
Field Date:	4/15/2011	Report Date:	4/15/2011	Barrier #:	6953A
Location:	Olive Tree Wy - South				
X Coordinate:	-121.26798				
Y Coordinate:	38.69122				
Barrier Area:	Curb Ramps				
Barrier Type:	Curb Ramp at Elbow - Cross Slope				
Code Ref:	CBC 1127B.5.3 and ADA/ABA 406.2

As Built Meas:	1	Quantity:	EACH
Description:	Elbow in roadway has non-compliant cross slope at curb ramp		
As Built Desc:	7.4% cross slope at ramp		
Solution:	Demolish existing and construct standard sidewalk		
Bar. Severity:	3 Hindrance	Cost Estimate:	\$2,500.00
Implementation Priority:	4	Facility Function:	
Implementation Phase:		Implementation Date:	
Official Responsible:

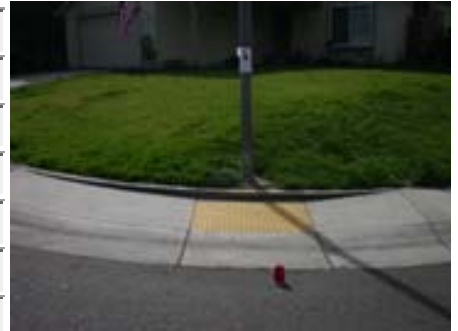
Field Date:	4/15/2011	Report Date:	4/15/2011	Barrier #:	6953B
Location:	Olive Tree Wy - South				
X Coordinate:	-121.26798				
Y Coordinate:	38.69122				
Barrier Area:	Curb Ramps				
Barrier Type:	Curb Ramp at Elbow - Landing (>5.0% or more)				
Code Ref:	CBC 1127B.5.4 and ADA/ABA 406.4

As Built Meas:	1	Quantity:	EACH
Description:	Curb ramp landing or pan not level (>5.0% or more)		
As Built Desc:	4.0% slope at ramp landing		
Solution:	Demolish existing and construct standard sidewalk		
Bar. Severity:	1 Necessary	Cost Estimate:	\$250.00
Implementation Priority:	4	Facility Function:	
Implementation Phase:		Implementation Date:	
Official Responsible:

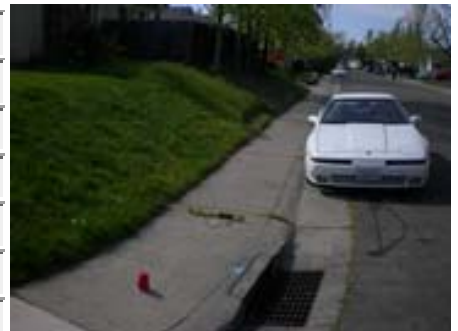
Field Date:	4/15/2011	Report Date:	4/15/2011	Barrier #:	6954
Location:	Olive Tree Wy - East				
X Coordinate:	-121.26793				
Y Coordinate:	38.69108				
Barrier Area:	Sidewalks				
Barrier Type:	Cross Slope - Existing (4.1% to 4.9%)				
Code Ref:	CBC 1133B.7.1.3 and ADA/ABA 403.3

As Built Meas:	373	Quantity:	LF
Description:	Cross slope exceeds 2.0% (4.1% to 4.9%)		
As Built Desc:	4.3% cross slope		
Solution:	Demolish existing and construct new route		
Bar. Severity:	2 Recommended	Cost Estimate:	\$46,625.00
Implementation Priority:	4	Facility Function:	
Implementation Phase:		Implementation Date:	
Official Responsible:

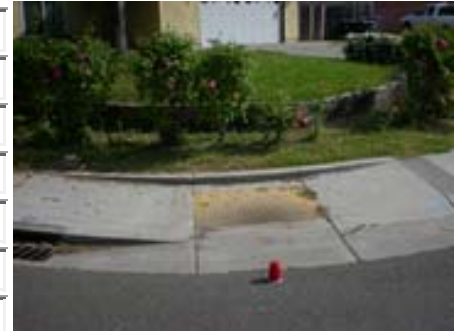
Field Date:	4/15/2011	Report Date:	4/15/2011	Barrier #:	6955
Location:	Olive Tree Wy and Olive Tree Wy Ct - Corner B				
X Coordinate:	-121.26791				
Y Coordinate:	38.69009				
Barrier Area:	Curb Ramps				
Barrier Type:	12" Grooves - Existing (3.1% to 4.0%)				
Code Ref:	CBC 1127B.5.6

As Built Meas:	1	Quantity:	EACH
Description:	12" grooves at top of curb ramp are not level (3.1% to 4.0%)		
As Built Desc:	3.1% at 12" grooves		
Solution:	Demolish existing and construct new curb ramp		
Bar. Severity:	3 Hindrance	Cost Estimate:	\$2,500.00
Implementation Priority:	4	Facility Function:	
Implementation Phase:		Implementation Date:	
Official Responsible:			
Notes:	Two - way intersection corners B,C. Corner C compliant

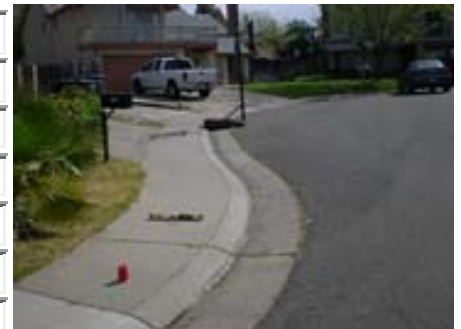
Field Date:	4/15/2011	Report Date:	4/15/2011	Barrier #:	6956
Location:	Olive Tree Ct - North				
X Coordinate:	-121.26787				
Y Coordinate:	38.69011				
Barrier Area:	Sidewalks				
Barrier Type:	Cross Slope - Existing (3.1% to 4.0%)				
Code Ref:	CBC 1133B.7.1.3 and ADA/ABA 403.3

As Built Meas:	107	Quantity:	LF
Description:	Cross slope exceeds 2.0% (3.1% to 4.0%)		
As Built Desc:	3.5% cross slope		
Solution:	Demolish existing and construct new route		
Bar. Severity:	3 Hindrance	Cost Estimate:	\$13,375.00
Implementation Priority:	4	Facility Function:	
Implementation Phase:		Implementation Date:	
Official Responsible:			
Notes:

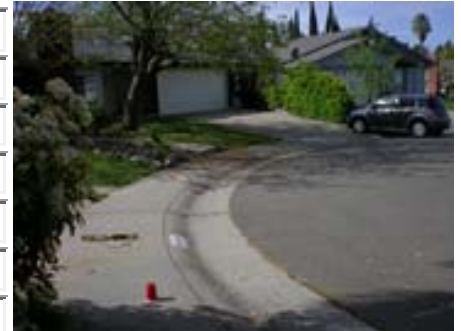
Barrier Type: Cross Slope - Existing (3.1% to 4.0%)

Code Ref: CBC 1133B.7.1.3 and ADA/ABA 403.3

As Built Meas: 80 Quantity: LF

Description: Cross slope exceeds 2.0% (3.1% to 4.0%)

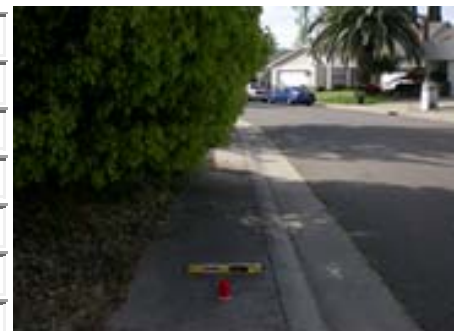
Barrier Type: Clear Width - Existing ($\leq 31"$ or less)

Code Ref: CBC 1133B.7.1

As Built Meas: 1 Quantity: LF

Description: Pedestrian route is not min. 48" wide ($\leq 31"$ or less)

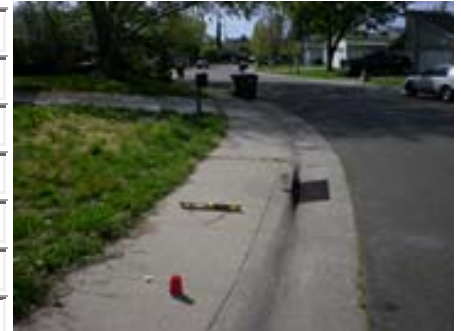
Field Date:	4/15/2011	Report Date:	4/15/2011	Barrier #:	6959
Location:	Olive Tree Wy - East				
X Coordinate:	-121.26787				
Y Coordinate:	38.68956				
Barrier Area:	Sidewalks				
Barrier Type:	Cross Slope - Existing (3.1% to 4.0%)				
Code Ref:	CBC 1133B.7.1.3 and ADA/ABA 403.3

As Built Meas:	402	Quantity:	LF
Description:	Cross slope exceeds 2.0% (3.1% to 4.0%)		
As Built Desc:	3.6% cross slope		
Solution:	Demolish existing and construct new route		
Bar. Severity:	3 Hindrance	Cost Estimate:	\$50,250.00
Implementation Priority:	4	Facility Function:	
Implementation Phase:		Implementation Date:	
Official Responsible:

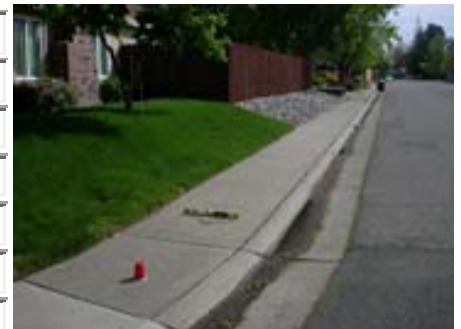
Field Date:	4/15/2011	Report Date:	4/15/2011	Barrier #:	6960
Location:	Larwin Dr - North				
X Coordinate:	-121.26724				
Y Coordinate:	38.68858				
Barrier Area:	Sidewalks				
Barrier Type:	Cross Slope - Existing (5.0% or more)				
Code Ref:	CBC 1133B.7.1.3 and ADA/ABA 403.3

As Built Meas:	312	Quantity:	LF
Description:	Cross slope exceeds 2.0% (5.0% or more)		
As Built Desc:	6.1% cross slope		
Solution:	Demolish existing and construct new route		
Bar. Severity:	1 Necessary	Cost Estimate:	\$39,000.00
Implementation Priority:	2	Facility Function:	
Implementation Phase:		Implementation Date:	
Official Responsible:

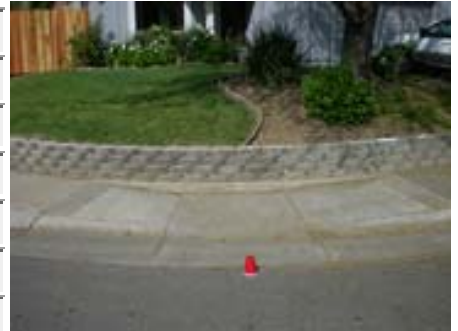
Field Date:	4/15/2011	Report Date:	4/15/2011	Barrier #:	6961A
Location:	Larwin Dr and Red Maple Wy - Corner A				
X Coordinate:	-121.26619				
Y Coordinate:	38.68887				
Barrier Area:	Curb Ramps				
Barrier Type:	12" Grooves - Existing (3.1% to 4.0%)				
Code Ref:	CBC 1127B.5.6

As Built Meas:	1	Quantity:	EACH
Description:	12" grooves at top of curb ramp are not level (3.1% to 4.0%)		
As Built Desc:	3.6% at 12" grooves		
Solution:	Demolish existing and construct new curb ramp		
Bar. Severity:	3 Hindrance	Cost Estimate:	\$2,500.00
Implementation Priority:	2	Facility Function:	
Implementation Phase:		Implementation Date:	
Official Responsible:

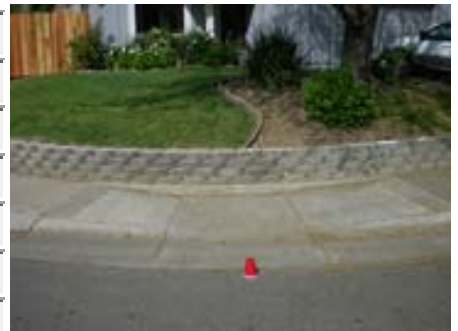
Field Date:	4/15/2011	Report Date:	4/15/2011	Barrier #:	6961B
Location:	Larwin Dr and Red Maple Wy - Corner A				
X Coordinate:	-121.26619				
Y Coordinate:	38.68887				
Barrier Area:	Curb Ramps				
Barrier Type:	Detectable Warnings - Truncated Domes				
Code Ref:	CBC 1127B.5.7 and ADA/ABA 705.1.3

As Built Meas:	1	Quantity:	EACH
Description:	No truncated domes provided at curb ramp		
As Built Desc:	No detectable warnings at curb ramp		
Solution:	Provide compliant truncated domes		
Bar. Severity:	2 Recommended	Cost Estimate:	\$0.00
Implementation Priority:	2	Facility Function:	
Implementation Phase:		Implementation Date:	
Official Responsible:

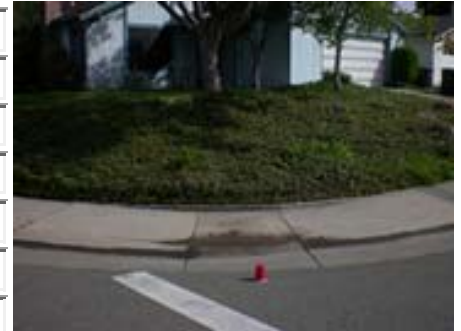
Field Date:	4/15/2011	Report Date:	4/15/2011	Barrier #:	6962A
Location:	Larwin Dr and Red Maple Wy - Corner B				
X Coordinate:	-121.26605				
Y Coordinate:	38.68893				
Barrier Area:	Curb Ramps				
Barrier Type:	12" Grooves - Existing (4.1% to 4.9%)				
Code Ref:	CBC 1127B.5.6

As Built Meas:	1	Quantity:	EACH
Description:	12" grooves at top of curb ramp are not level (4.1% to 4.9%)		
As Built Desc:	4.6% at 12" grooves		
Solution:	Demolish existing and construct new curb ramp		
Bar. Severity:	2 Recommended	Cost Estimate:	\$2,500.00
Implementation Priority:	2	Facility Function:	
Implementation Phase:		Implementation Date:	
Official Responsible:

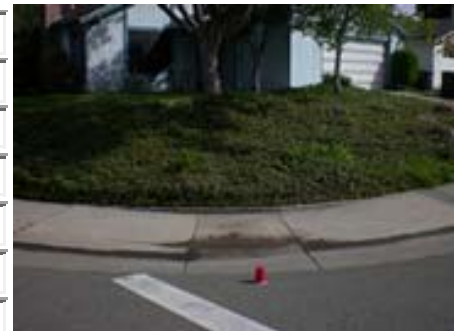
Field Date:	4/15/2011	Report Date:	4/15/2011	Barrier #:	6962B
Location:	Larwin Dr and Red Maple Wy - Corner B				
X Coordinate:	-121.26605				
Y Coordinate:	38.68893				
Barrier Area:	Curb Ramps				
Barrier Type:	Cross Slope - Existing (2.1% to 3.0%)				
Code Ref:	CBC 1127B.5.3 and ADA/ABA 406.2

As Built Meas:	1	Quantity:	EACH
Description:	Ramp run cross slope exceeds 2.0% (2.1% to 3.0%)		
As Built Desc:	2.8% cross slope		
Solution:	Demolish existing and construct new curb ramp		
Bar. Severity:	4 Low Severity	Cost Estimate:	\$0.00
Implementation Priority:	2	Facility Function:	
Implementation Phase:		Implementation Date:	
Official Responsible:

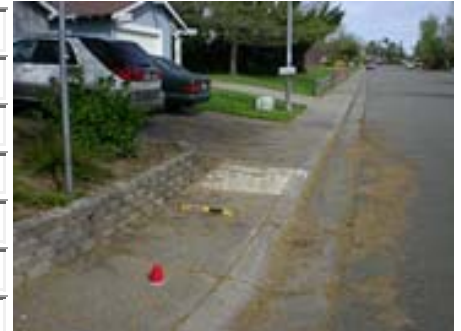
Field Date:	4/15/2011	Report Date:	4/15/2011	Barrier #:	6963
Location:	Red Maple Wy - West				
X Coordinate:	-121.26623				
Y Coordinate:	38.68893				
Barrier Area:	Sidewalks				
Barrier Type:	Cross Slope - Existing (3.1% to 4.0%)				
Code Ref:	CBC 1133B.7.1.3 and ADA/ABA 403.3

As Built Meas:	61	Quantity:	LF
Description:	Cross slope exceeds 2.0% (3.1% to 4.0%)		
As Built Desc:	3.4% cross slope		
Solution:	Demolish existing and construct new route		
Bar. Severity:	3 Hindrance	Cost Estimate:	\$7,625.00
Implementation Priority:	4	Facility Function:	
Implementation Phase:		Implementation Date:	
Official Responsible:

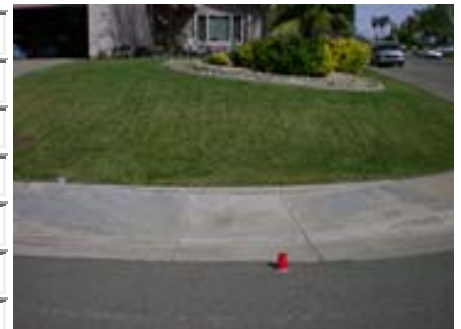
Field Date:	4/15/2011	Report Date:	4/15/2011	Barrier #:	6964A
Location:	Red Maple Wy and Red Maple Ct - Corner A				
X Coordinate:	-121.26655				
Y Coordinate:	38.68954				
Barrier Area:	Curb Ramps				
Barrier Type:	12" Grooves - Existing (>5.0%)				
Code Ref:	CBC 1127B.5.6

As Built Meas:	1	Quantity:	EACH
Description:	12" grooves at top of curb ramp are not level (>5.0%)		
As Built Desc:	5.5% at 12" grooves		
Solution:	Demolish existing and construct new curb ramp		
Bar. Severity:	1 Necessary	Cost Estimate:	\$2,500.00
Implementation Priority:	4	Facility Function:	
Implementation Phase:		Implementation Date:	
Official Responsible:

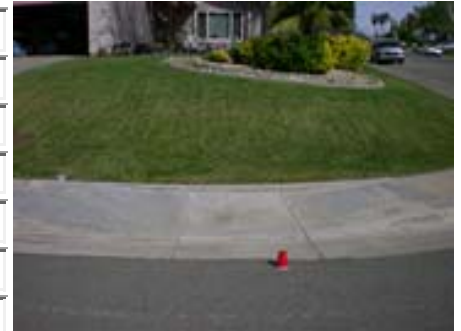
Barrier Type: Cross Slope - Existing (4.1% to 4.9%)

Code Ref: CBC 1127B.5.3 and ADA/ABA 406.2

As Built Meas: 1 Quantity: EACH

Description: Ramp run cross slope exceeds 2.0% (4.1% to 4.9%)

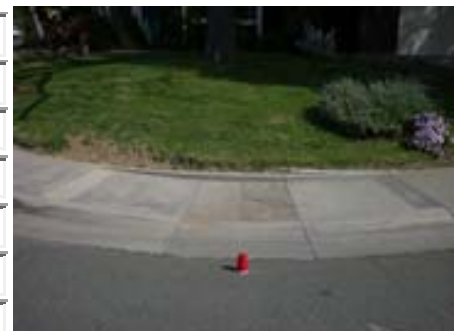
Barrier Type: 12" Grooves - Existing (>5.0%)

Code Ref: CBC 1127B.5.6

As Built Meas: 1 Quantity: EACH

Description: 12" grooves at top of curb ramp are not level (>5.0%)

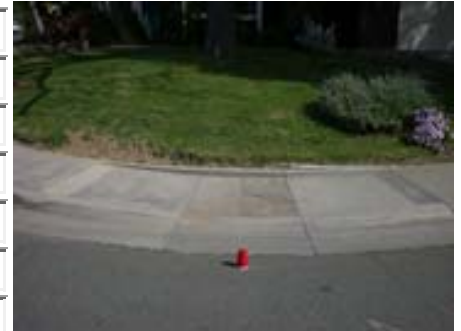
Field Date:	4/15/2011	Report Date:	4/15/2011	Barrier #:	6965B
Location:	Red Maple Wy and Black Walnut Ct - Corner B				
X Coordinate:	-121.2663				
Y Coordinate:	38.68962				
Barrier Area:	Curb Ramps				
Barrier Type:	Detectable Warnings - Truncated Domes				
Code Ref:	CBC 1127B.5.7 and ADA/ABA 705.1.3

As Built Meas:	1	Quantity:	EACH
Description:	No truncated domes provided at curb ramp		
As Built Desc:	No detectable warnings at curb ramp		
Solution:	Provide compliant truncated domes		
Bar. Severity:	2 Recommended	Cost Estimate:	\$0.00
Implementation Priority:	4	Facility Function:	
Implementation Phase:		Implementation Date:	
Official Responsible:

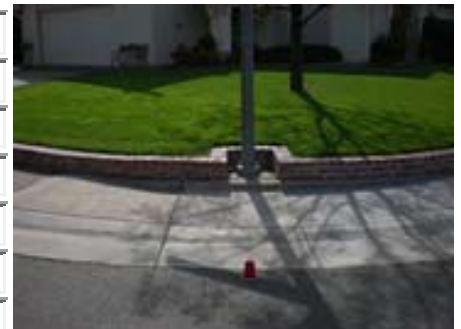
Field Date:	4/15/2011	Report Date:	4/15/2011	Barrier #:	6966A
Location:	Red Maple Wy and Black Walnut Ct - Corner C				
X Coordinate:	-121.26631				
Y Coordinate:	38.68954				
Barrier Area:	Curb Ramps				
Barrier Type:	12" Grooves - Existing (3.1% to 4.0%)				
Code Ref:	CBC 1127B.5.6

As Built Meas:	1	Quantity:	EACH
Description:	12" grooves at top of curb ramp are not level (3.1% to 4.0%)		
As Built Desc:	3.1% at 12" grooves		
Solution:	Demolish existing and construct new curb ramp		
Bar. Severity:	3 Hindrance	Cost Estimate:	\$2,500.00
Implementation Priority:	4	Facility Function:	
Implementation Phase:		Implementation Date:	
Official Responsible:

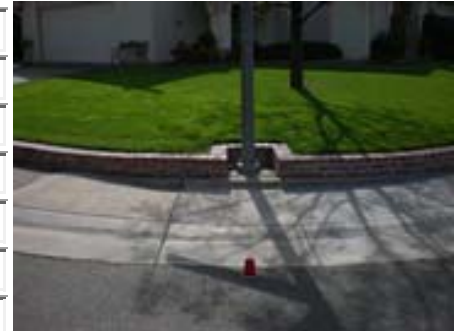
Barrier Type: Cross Slope - Existing (2.1% to 3.0%)

Code Ref: CBC 1127B.5.3 and ADA/ABA 406.2

As Built Meas: 1 Quantity: EACH

Description: Ramp run cross slope exceeds 2.0% (2.1% to 3.0%)

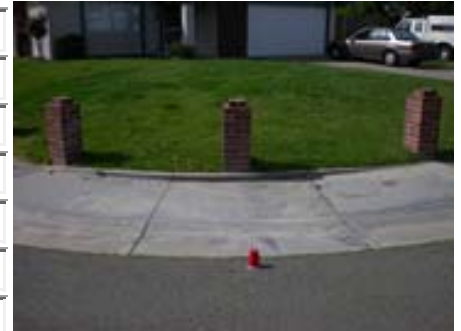
Barrier Type: Detectable Warnings - Truncated Domes

Code Ref: CBC 1127B.5.7 and ADA/ABA 705.1.3

As Built Meas: 1 Quantity: EACH

Description: No truncated domes provided at curb ramp

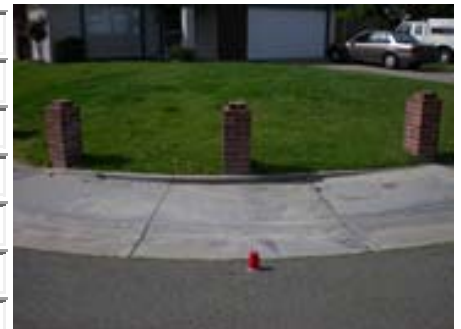
Barrier Type: Gutter Slope - Existing (6.6% to 8.2%)

Code Ref: CBC 1127B.5.3 and ADA/ABA 406.2

As Built Meas: 6 Quantity: SF

Description: Gutter slope exceeds 5.0% (6.6% to 8.2%)

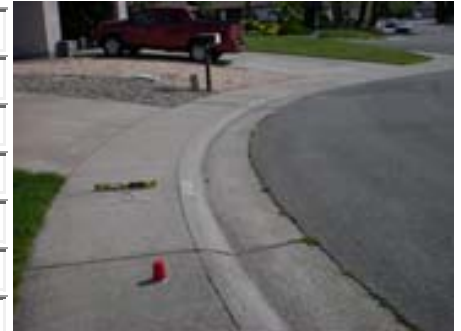
Barrier Type: Cross Slope - Existing (3.1% to 4.0%)

Code Ref: CBC 1133B.7.1.3 and ADA/ABA 403.3

As Built Meas: 85 Quantity: LF

Description: Cross slope exceeds 2.0% (3.1% to 4.0%)

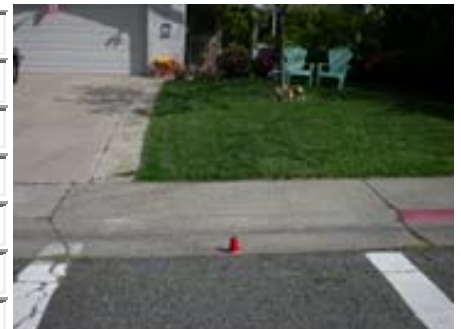
Barrier Type: No Curb Ramp

Code Ref: CBC 1127B.5.1 and ADA/ABA 402.2

As Built Meas: 1 Quantity: EACH

Description: No curb cut at corner (intersection)

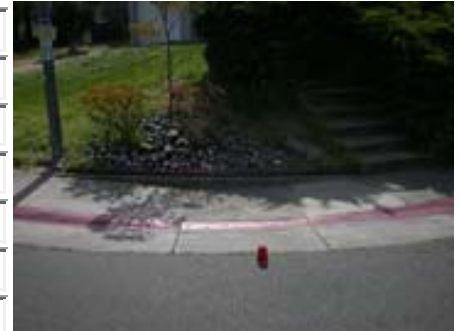
Field Date:	4/15/2011	Report Date:	4/15/2011	Barrier #:	6970A
Location:	Red Maple Wy and Woodmore Oaks Dr - Corner C				
X Coordinate:	-121.2669				
Y Coordinate:	38.69192				
Barrier Area:	Curb Ramps				
Barrier Type:	12" Grooves - Existing (>5.0%)				
Code Ref:	CBC 1127B.5.6

As Built Meas:	1	Quantity:	EACH
Description:	12" grooves at top of curb ramp are not level (>5.0%)		
As Built Desc:	8.9% at 12" grooves		
Solution:	Demolish existing and construct new curb ramp		
Bar. Severity:	1 Necessary	Cost Estimate:	\$2,500.00
Implementation Priority:	4	Facility Function:	
Implementation Phase:		Implementation Date:	
Official Responsible:

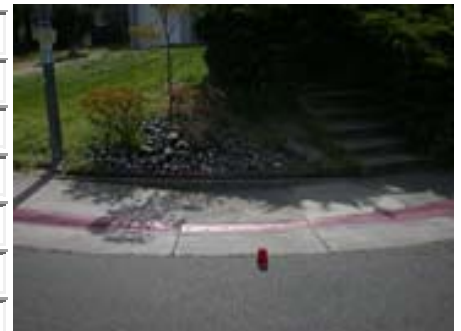
Field Date:	4/15/2011	Report Date:	4/15/2011	Barrier #:	6970B
Location:	Red Maple Wy and Woodmore Oaks Dr - Corner C				
X Coordinate:	-121.2669				
Y Coordinate:	38.69192				
Barrier Area:	Curb Ramps				
Barrier Type:	Running Slope - Existing (9.5% or more)				
Code Ref:	CBC 1127B.5.3 and ADA/ABA 406.1

As Built Meas:	1	Quantity:	EACH
Description:	Ramp run cross slope exceeds 2.0% (9.5% or more)		
As Built Desc:	9.8% running slope		
Solution:	Demolish existing and construct new curb ramp		
Bar. Severity:	1 Necessary	Cost Estimate:	\$0.00
Implementation Priority:	4	Facility Function:	
Implementation Phase:		Implementation Date:	
Official Responsible:

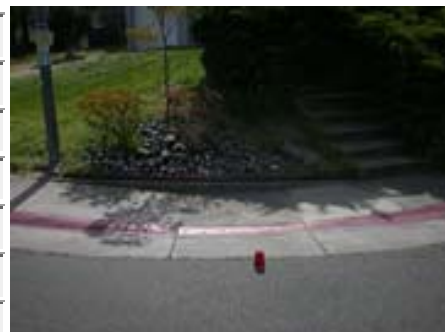
Field Date:	4/15/2011	Report Date:	4/15/2011	Barrier #:	6970E
Location:	Red Maple Wy and Woodmore Oaks Dr - Corner C				
X Coordinate:	-121.2669				
Y Coordinate:	38.69192				
Barrier Area:	Curb Ramps				
Barrier Type:	Gutter Slope - Existing (8.3% or more)				
Code Ref:	CBC 1127B.5.3 and ADA/ABA 406.2

As Built Meas:	6	Quantity:	SF
Description:	Gutter slope exceeds 5.0% (8.3% or more)		
As Built Desc:	8.4% gutter slope		
Solution:	Demolish existing and construct new gutter		
Bar. Severity:	1 Necessary	Cost Estimate:	\$0.00
Implementation Priority:	4	Facility Function:	
Implementation Phase:		Implementation Date:	
Official Responsible:			
Notes:	Three - way intersection corners B, C, D

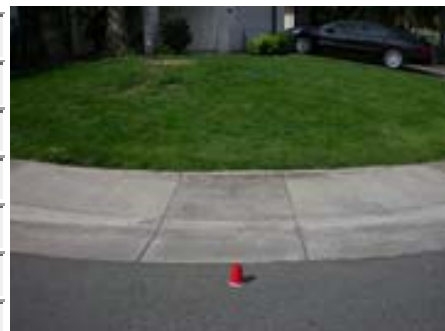
Field Date:	4/15/2011	Report Date:	4/15/2011	Barrier #:	6971A
Location:	Red Maple Wy and Woodmore Oaks Dr - Corner D				
X Coordinate:	-121.26705				
Y Coordinate:	38.69191				
Barrier Area:	Curb Ramps				
Barrier Type:	Detectable Warnings - Truncated Domes				
Code Ref:	CBC 1127B.5.7 and ADA/ABA 705.1.3

As Built Meas:	1	Quantity:	EACH
Description:	No truncated domes provided at curb ramp		
As Built Desc:	No detectable warnings at curb ramp		
Solution:	Provide compliant truncated domes		
Bar. Severity:	2 Recommended	Cost Estimate:	\$1,400.00
Implementation Priority:	4	Facility Function:	
Implementation Phase:		Implementation Date:	
Official Responsible:			
Notes:	Three - way intersection corners B, C, D

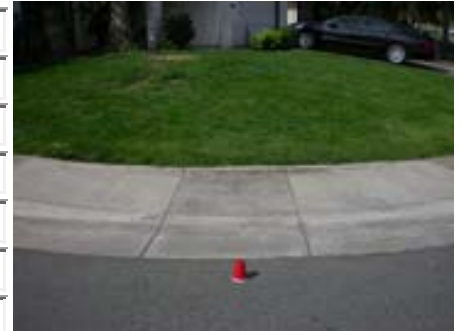
Field Date:	4/15/2011	Report Date:	4/15/2011	Barrier #:	6971B
Location:	Red Maple Wy and Woodmore Oaks Dr - Corner D				
X Coordinate:	-121.26705				
Y Coordinate:	38.69191				
Barrier Area:	Curb Ramps				
Barrier Type:	Gutter Slope - Existing (6.6% to 8.2%)				
Code Ref:	CBC 1127B.5.3 and ADA/ABA 406.2

As Built Meas:	6	Quantity:	SF
Description:	Gutter slope exceeds 5.0% (6.6% to 8.2%)		
As Built Desc:	7.3% gutter slope		
Solution:	Demolish existing and construct new gutter		
Bar. Severity:	2 Recommended	Cost Estimate:	\$750.00
Implementation Priority:	4	Facility Function:	
Implementation Phase:		Implementation Date:	
Official Responsible:			
Notes:	Three - way intersection corners B, C, D

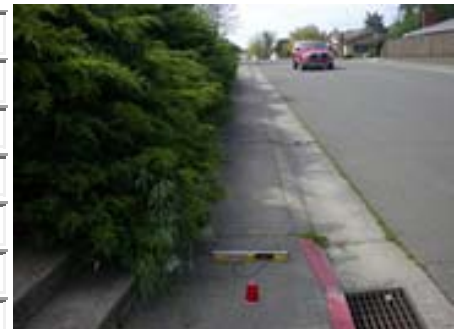
Field Date:	4/15/2011	Report Date:	4/15/2011	Barrier #:	6972
Location:	Red Maple Wy - East				
X Coordinate:	-121.26688				
Y Coordinate:	38.69188				
Barrier Area:	Sidewalks				
Barrier Type:	Clear Width - Existing ($\leq 31"$ or less)				
Code Ref:	CBC 1133B.7.1

As Built Meas:	76	Quantity:	LF
Description:	Pedestrian route is not min. 48" wide ($\leq 31"$ or less)		
As Built Desc:	26" clear width due to foliage		
Solution:	Demolish existing and construct new route		
Bar. Severity:	1 Necessary	Cost Estimate:	\$9,500.00
Implementation Priority:	4	Facility Function:	
Implementation Phase:		Implementation Date:	
Official Responsible:			
Notes:

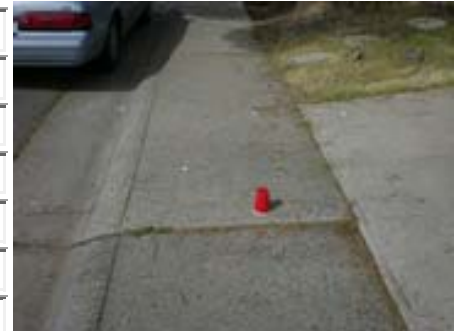
Field Date:	4/15/2011	Report Date:	4/15/2011	Barrier #:	6973
Location:	Black Walnut Ct - North				
X Coordinate:	-121.26605				
Y Coordinate:	38.68967				
Barrier Area:	Sidewalks				
Barrier Type:	Abrupt Change in Level - > 1/2"				
Code Ref:	CBC 1133B.7.1 and ADA/ABA 303.3

As Built Meas:	4	Quantity:	LF
Description:	Change in level greater than 1/2"		
As Built Desc:	1/2" lip in sidewalk surface		
Solution:	Grind or repair sidewalk to remove trip hazard		
Bar. Severity:	1 Necessary	Cost Estimate:	\$1,000.00
Implementation Priority:	4	Facility Function:	
Implementation Phase:		Implementation Date:	
Official Responsible:			
Notes:

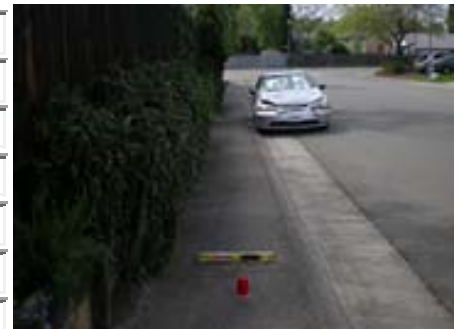
Field Date:	4/15/2011	Report Date:	4/15/2011	Barrier #:	6974
Location:	Red Maple Wy - East				
X Coordinate:	-121.26623				
Y Coordinate:	38.68933				
Barrier Area:	Sidewalks				
Barrier Type:	Clear Width - Existing ($\leq 31"$ or less)				
Code Ref:	CBC 1133B.7.1

As Built Meas:	1	Quantity:	LF
Description:	Pedestrian route is not min. 48" wide ($\leq 31"$ or less)		
As Built Desc:	30" clear width due to foliage		
Solution:	Trim foliage to provide min. 48" clear width		
Bar. Severity:	1 Necessary	Cost Estimate:	\$125.00
Implementation Priority:	4	Facility Function:	
Implementation Phase:		Implementation Date:	
Official Responsible:			
Notes:

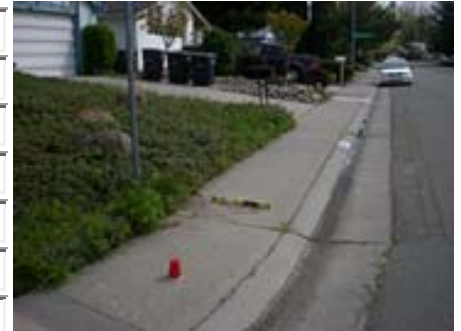
Field Date:	4/15/2011	Report Date:	4/15/2011	Barrier #:	6975
Location:	Larwin Dr - North				
X Coordinate:	-121.26594				
Y Coordinate:	38.68894				
Barrier Area:	Sidewalks				
Barrier Type:	Cross Slope - Existing (5.0% or more)				
Code Ref:	CBC 1133B.7.1.3 and ADA/ABA 403.3

As Built Meas:	352	Quantity:	LF
Description:	Cross slope exceeds 2.0% (5.0% or more)		
As Built Desc:	7.1% cross slope		
Solution:	Demolish existing and construct new route		
Bar. Severity:	1 Necessary	Cost Estimate:	\$44,000.00
Implementation Priority:	2	Facility Function:	
Implementation Phase:		Implementation Date:	
Official Responsible:

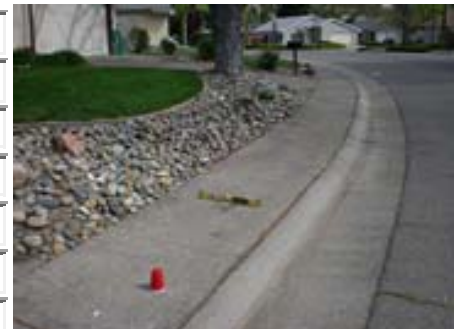
Field Date:	4/15/2011	Report Date:	4/15/2011	Barrier #:	6976
Location:	Larwin Dr - West				
X Coordinate:	-121.26484				
Y Coordinate:	38.68926				
Barrier Area:	Sidewalks				
Barrier Type:	Cross Slope - Existing (5.0% or more)				
Code Ref:	CBC 1133B.7.1.3 and ADA/ABA 403.3

As Built Meas:	337	Quantity:	LF
Description:	Cross slope exceeds 2.0% (5.0% or more)		
As Built Desc:	5.3% cross slope		
Solution:	Demolish existing and construct new route		
Bar. Severity:	1 Necessary	Cost Estimate:	\$42,125.00
Implementation Priority:	2	Facility Function:	
Implementation Phase:		Implementation Date:	
Official Responsible:

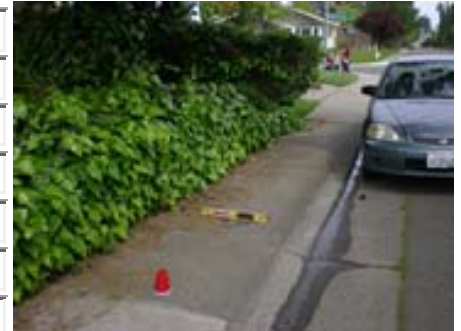
Field Date:	4/15/2011	Report Date:	4/15/2011	Barrier #:	6977
Location:	Larwin Dr - West				
X Coordinate:	-121.2646				
Y Coordinate:	38.69024				
Barrier Area:	Sidewalks				
Barrier Type:	Cross Slope - Existing (3.1% to 4.0%)				
Code Ref:	CBC 1133B.7.1.3 and ADA/ABA 403.3

As Built Meas:	72	Quantity:	LF
Description:	Cross slope exceeds 2.0% (3.1% to 4.0%)		
As Built Desc:	3.3% cross slope		
Solution:	Demolish existing and construct new route		
Bar. Severity:	3 Hindrance	Cost Estimate:	\$9,000.00
Implementation Priority:	2	Facility Function:	
Implementation Phase:		Implementation Date:	
Official Responsible:

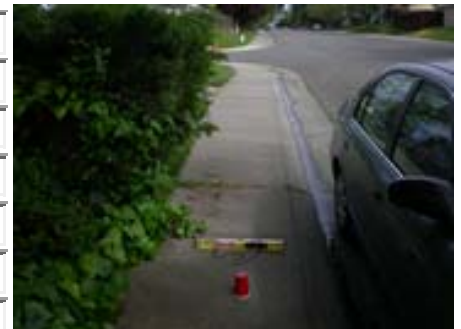
Field Date:	4/15/2011	Report Date:	4/15/2011	Barrier #:	6978
Location:	Larwin Dr - West				
X Coordinate:	-121.2646				
Y Coordinate:	38.69027				
Barrier Area:	Sidewalks				
Barrier Type:	Clear Width - Existing ($\leq 31"$ or less)				
Code Ref:	CBC 1133B.7.1

As Built Meas:	1	Quantity:	LF
Description:	Pedestrian route is not min. 48" wide ($\leq 31"$ or less)		
As Built Desc:	28" clear width due to foliage		
Solution:	Trim foliage to provide min. 48" clear width		
Bar. Severity:	1 Necessary	Cost Estimate:	\$125.00
Implementation Priority:	2	Facility Function:	
Implementation Phase:		Implementation Date:	
Official Responsible:

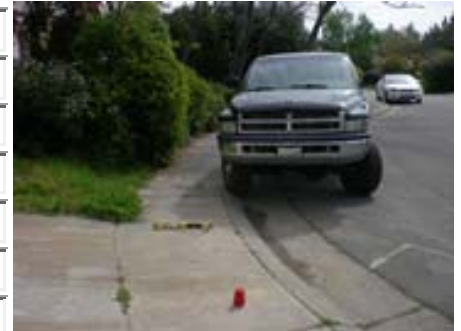
Field Date:	4/15/2011	Report Date:	4/15/2011	Barrier #:	6979A
Location:	Peppermint Ct - North				
X Coordinate:	-121.26579				
Y Coordinate:	38.69067				
Barrier Area:	Sidewalks				
Barrier Type:	Cross Slope - Existing (4.1% to 4.9%)				
Code Ref:	CBC 1133B.7.1.3 and ADA/ABA 403.3

As Built Meas:	190	Quantity:	LF
Description:	Cross slope exceeds 2.0% (4.1% to 4.9%)		
As Built Desc:	4.3% cross slope		
Solution:	Demolish existing and construct new route		
Bar. Severity:	2 Recommended	Cost Estimate:	\$23,750.00
Implementation Priority:	4	Facility Function:	
Implementation Phase:		Implementation Date:	
Official Responsible:

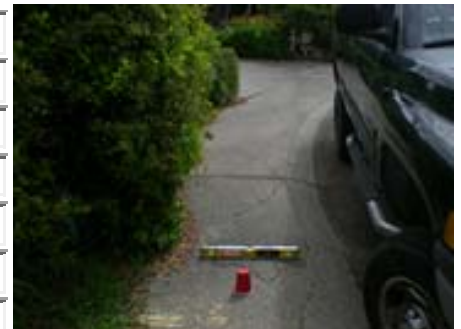
Field Date:	4/15/2011	Report Date:	4/15/2011	Barrier #:	6979B
Location:	Peppermint Ct - North				
X Coordinate:	-121.26575				
Y Coordinate:	38.69067				
Barrier Area:	Sidewalks				
Barrier Type:	Clear Width - Existing ($\leq 31"$ or less)				
Code Ref:	CBC 1133B.7.1

As Built Meas:	1	Quantity:	LF
Description:	Pedestrian route is not min. 48" wide ($\leq 31"$ or less)		
As Built Desc:	28" clear width due to foliage		
Solution:	Trim foliage to provide min. 48" clear width		
Bar. Severity:	1 Necessary	Cost Estimate:	\$125.00
Implementation Priority:	4	Facility Function:	
Implementation Phase:		Implementation Date:	
Official Responsible:

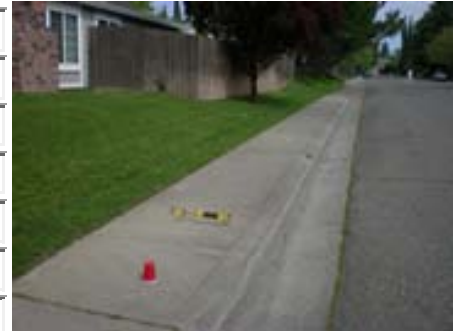
Field Date:	4/15/2011	Report Date:	4/15/2011	Barrier #:	6980
Location:	Larwin Dr - West				
X Coordinate:	-121.2646				
Y Coordinate:	38.69067				
Barrier Area:	Sidewalks				
Barrier Type:	Cross Slope - Existing (4.1% to 4.9%)				
Code Ref:	CBC 1133B.7.1.3 and ADA/ABA 403.3

As Built Meas:	190	Quantity:	LF
Description:	Cross slope exceeds 2.0% (4.1% to 4.9%)		
As Built Desc:	4.5% cross slope		
Solution:	Demolish existing and construct new route		
Bar. Severity:	2 Recommended	Cost Estimate:	\$23,750.00
Implementation Priority:	2	Facility Function:	
Implementation Phase:		Implementation Date:	
Official Responsible:

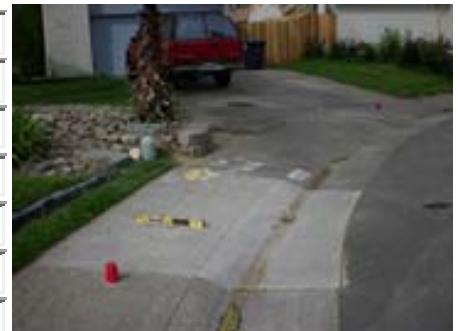
Field Date:	4/15/2011	Report Date:	4/15/2011	Barrier #:	6981
Location:	Red Pine Ct - South				
X Coordinate:	-121.26541				
Y Coordinate:	38.69121				
Barrier Area:	Sidewalks				
Barrier Type:	Cross Slope - Existing (5.0% or more)				
Code Ref:	CBC 1133B.7.1.3 and ADA/ABA 403.3

As Built Meas:	31	Quantity:	LF
Description:	Cross slope exceeds 2.0% (5.0% or more)		
As Built Desc:	5.9% cross slope		
Solution:	Demolish existing and construct new route		
Bar. Severity:	1 Necessary	Cost Estimate:	\$3,875.00
Implementation Priority:	4	Facility Function:	
Implementation Phase:		Implementation Date:	
Official Responsible:

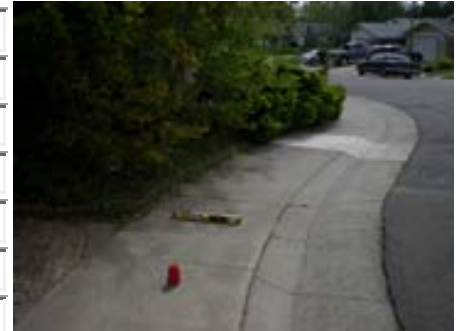
Field Date:	4/15/2011	Report Date:	4/15/2011	Barrier #:	6982A
Location:	Red Pine Ct - North				
X Coordinate:	-121.26539				
Y Coordinate:	38.69141				
Barrier Area:	Sidewalks				
Barrier Type:	Cross Slope - Existing (2.1% to 3.0%)				
Code Ref:	CBC 1133B.7.1.3 and ADA/ABA 403.3

As Built Meas:	64	Quantity:	LF
Description:	Cross slope exceeds 2.0% (2.1% to 3.0%)		
As Built Desc:	2.9% cross slope		
Solution:	Low severity barrier - no remediation recommended		
Bar. Severity:	4 Low Severity	Cost Estimate:	\$0.00
Implementation Priority:	4	Facility Function:	
Implementation Phase:		Implementation Date:	
Official Responsible:
